Flood Control Project Maintenance Levee Inspections

Fall 2022 Levee Maintenance Deficiency Summary Report

San Joaquin River Basin

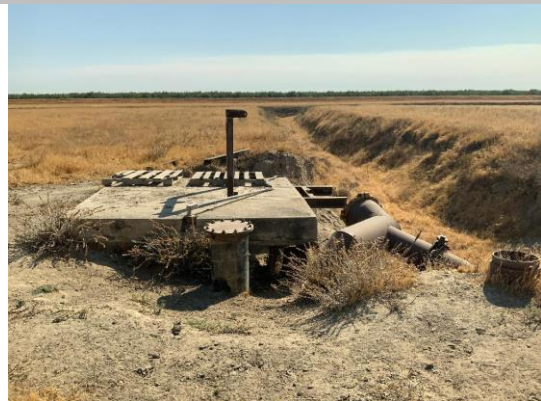
Photo 1 of 2 : UCIP_FA_2022_71143_101613.jpg

Comment Code						
Inspector Comment						
DS_ID:19879 FS_ID:71143 EP_NO: 13638 Repair Type: Non-Urgent EVAL Issue: 10, Unauthorized Modification or Non-Compliant Permit Crossing Status: Found UCIP Comments: 07/12/2021 The record remains Non-Urgent. WS pump removed and wires cut. Large pieces of pipe appear to be out of place, crossing appears abandoned. Pump off LS toe behind fence is running for well water. Recommend contacting owner to confirm status of crossing. Erosion and instability underneath concrete pad meant for pump on the edge of the WS outlet channel. The UCIP inspection was completed with GEI staff, P. Espinoza. (H. Dunn – GEI) 04/17/2014 Need to contact owner to determine status. Crossing has been modified. (O. Magana - DWR UCIP) FIELD_STRUCT_DESC: 16-inch coated steel irrigation discharge pipe through the levee, 3.5 feet below the crown. Cutoff wall around the pipe at the center of the levee. Pump on the waterside (WS). Siphon breaker on the landside (LS) shoulder. Intake trench on the WS. (Pump and 16-inch pipe authorized under Permit No. 13638, 1983 - Hamonds Ranch). [Additional Reference(s): DWR Levee Log, 2002, (HLM 23.92)]. FS Date: 7/12/2021

WS view: Pump removed and pipes displaced at toe.

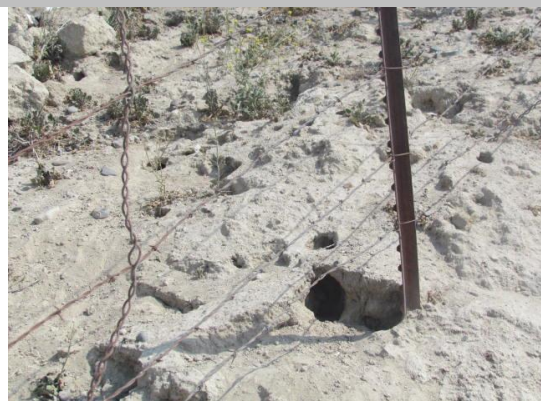
Photo 1 of 1 : FA_2022_NA0010_124_1208_20220822_00062.jpg

LM Start	26.13	Rating **	M	Issue No.	1208
LM End	26.13	Issue Type +	Ma	Location *	LS
Category	Earthen Levee			GPS Latitude/Longitude	
				Start	End
Item	Animal Control			37.054222 °	37.054222 °
				-120.500862 °	-120.500862 °
DWR ID	DWR_NA0010_06_s_2015_1208				
Comment Code					
A3 : No rodents visible, but rodent burrows visible; need to backfill and compact or grout burrows.					
Inspector Comment					
Noted several rodent holes next to and within rock revetment on landside slope.

Rodent holes on landward slope.

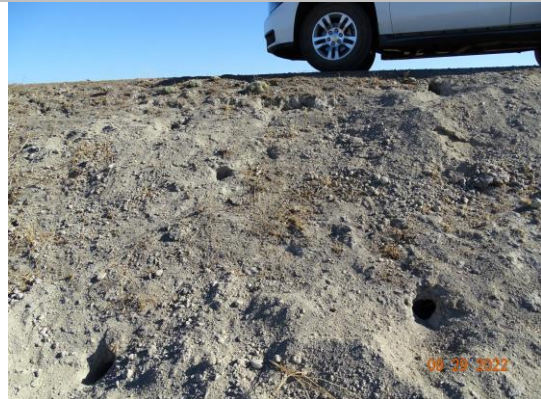
Photo 1 of 1 : FA_2022_NA0010_124_140_20221012_00252.jpg

LM Start	26.37	Rating **	M	Issue No.	140
LM End	26.37	Issue Type +	Ma	Location *	LS
Category	Earthen Levee			GPS Latitude/Longitude	
				Start	End
Item	Animal Control			37.051751 °	37.051751 °
				-120.497801 °	-120.497801 °
DWR ID	DWR_NA0010_06_f_2022_140				
Comment Code					
A3 : No rodents visible, but rodent burrows visible; need to backfill and compact or grout burrows.					
Inspector Comment

View of multiple animal holes in the landside slope. (Fall 2022)

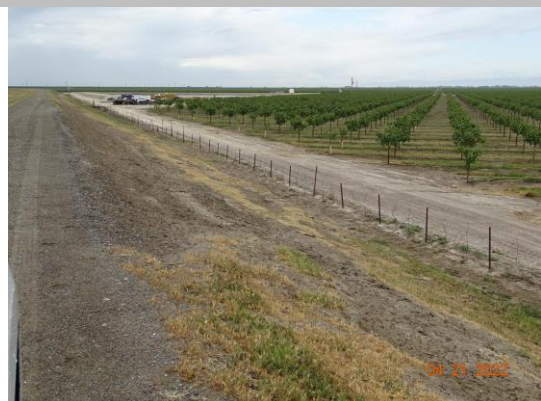
Photo 1 of 1 : FA_2022_NA0010_124_3_20220822_00001.jpg

LM Start	27.43	Rating **	U	Issue No.	3
LM End	27.99	Issue Type +	Ma	Location *	LS
Category	Earthen Levee			GPS Latitude/Longitude	
				Start	End
Item	Erosion / Livestock			37.036955 °	37.032762 °
				-120.484395 °	-120.481078 °
DWR ID	DWR_NA0010_06_s_2012_3				
Comment Code					
E4 : Repair the levee slope damaged by livestock and prevent large animal access.					
Inspector Comment					
Landside erosion and slope instability caused by livestock. Erosion greater than 3" in depth on landside slope. Levee crown has narrowed within this reach.

Looking south along landside slope. (Spring 2022)

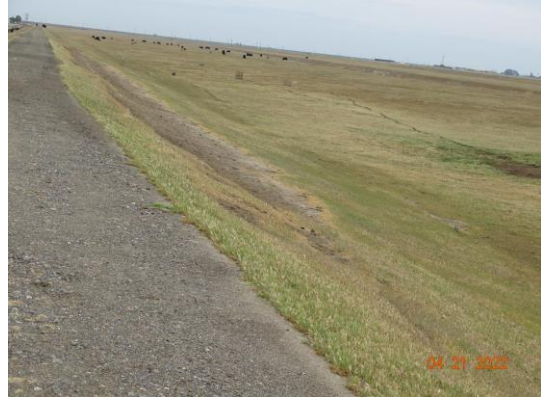
Photo 1 of 1 : FA_2022_NA0010_124_132_20220822_00050.jpg

LM Start	27.65	Rating **	M	Issue No.	132
LM End	27.93	Issue Type +	Ma	Location *	WS
Category	Earthen Levee			GPS Latitude/Longitude	
				Start	End
Item	Erosion / Livestock			37.036856 °	37.033468 °
				-120.484309 °	-120.481709 °
DWR ID	DWR_NA0010_06_s_2022_132				
Comment Code					
E4 : Repair the levee slope damaged by livestock and prevent large animal access.					
Inspector Comment

View of erosion on the waterside slope. (Spring 2022)

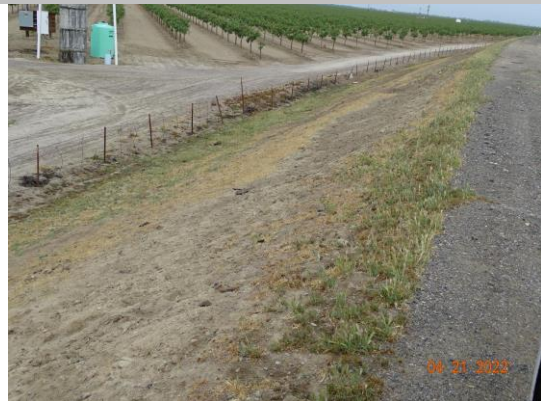
Photo 1 of 1 : FA_2022_NA0010_124_131_20220822_00049.jpg

LM Start	28.18	Rating **	A/W	Issue No.	131
LM End	28.18	Issue Type +	Ma	Location *	LS
Category	Earthen Levee			GPS Latitude/Longitude	
				Start	End
Item	Erosion / Livestock			37.030925 °	37.030925 °
				-120.478368 °	-120.478368 °
DWR ID	DWR_NA0010_06_s_2022_131				
Comment Code					
E4 : Repair the levee slope damaged by livestock and prevent large animal access.					
Inspector Comment

View of damage to the landside slope. (Spring 2022)

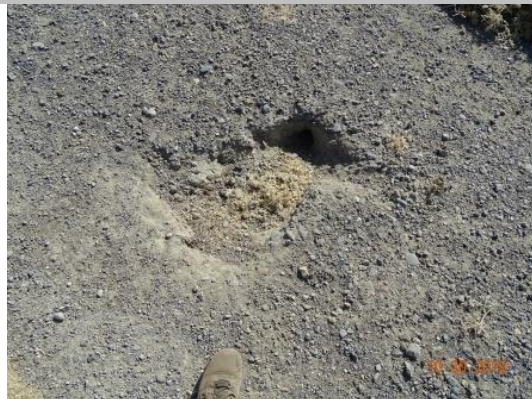
Photo 1 of 1 : FA_2022_NA0010_124_19_20220822_00004.jpg

LM Start	28.47	Rating **	M	Issue No.	19
LM End	28.53	Issue Type +	Ma	Location *	LS
Category	Earthen Levee			GPS Latitude/Longitude	
				Start	End
Item	Animal Control			37.029937 °	37.029977 °
				-120.473384 °	-120.472266 °
DWR ID	DWR_NA0010_06_s_2015_19				
Comment Code					
A3 : No rodents visible, but rodent burrows visible; need to backfill and compact or grout burrows.					
Inspector Comment					
Rodent burrows on the landside slope and crown.

View of rodent burrow in the levee crown. (Fall 2019)

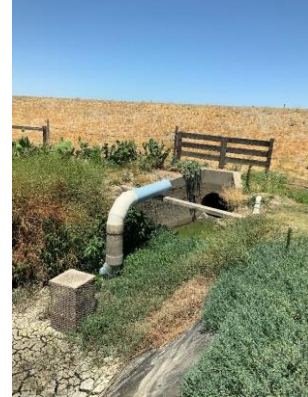
Photo 1 of 3 : UCIP_FA_2022_71146_103939.jpg

Comment Code					
Inspector Comment					
DS_ID:19881 FS_ID:71146 EP_NO: N/A Repair Type: Non-Urgent EVAL Issue: 4b, Safety Issue Crossing Status: Found UCIP Comments: 06/24/2021 The record remains Non-Urgent. WS inlet had sediment build up in pipe; recommend removal. Build up of debris in CMP riser on WS slope; recommend removal. WS CMP riser is missing lid, causing safety hazard. LS pipe outlet had elevated water levels around the headwall and pipe, limited ability to inspect closely. Unidentified pipe has been installed off 15 feet from the toe of LS headwall; does not affect crossing. No permit was found authorizing this encroachment. CVFPB will need to review crossing to determine owner. The UCIP inspection was completed with GEI staff, H.Dunn. (P.Espinoza – GEI) 04/10/2014 Dense vegetation limits the inspector's visibility to identify signs of pipe failure (leaks) along the slopes. Recommend removing vegetation along pipe alignment to conduct proper inspection of structure. (O. Magana - DWR UCIP) FIELD_STRUCT_DESC: 36-inch corrugated metal gravity irrigation pipe (CMP) through the levee, 12.4 feet below the crown. Slide gate in a 48-inch CMP riser unit on the waterside (WS) slope. Concrete U-shaped headwall on each end. Cobble pad on the landside (LS). [Additional Reference(s): DWR Levee Log, 2002, (HLM 29.34). USACE San Joaquin O&M Manual, Unit No. 601, Part No. 1, 1967, Amended in 1978, Revised 20 June 1985, (HLM 29.34). DWR As-Built Specification No. 64-01, Sheet No. 10, 6 November 1963, (HLM 29.34)]. FS Date: 6/24/2021 4:24:00 PM

LS view: Concrete headwall and slope from toe. Unidentified pipes near entrance of outlet pipe.

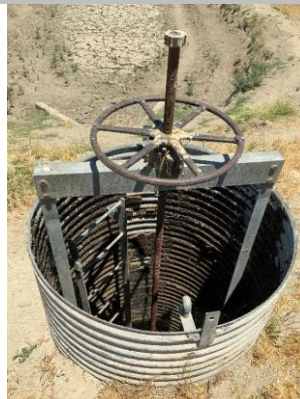
Photo 2 of 3 : UCIP_FA_2022_71146_103935.jpg

WS view: Close up of CMP riser with slide gate located on slope.

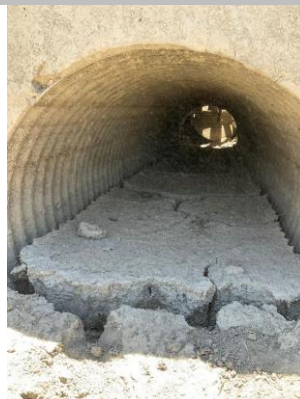
Photo 3 of 3 : UCIP_FA_2022_71146_103938.jpg

WS view: Inside of inlet pipe at toe.

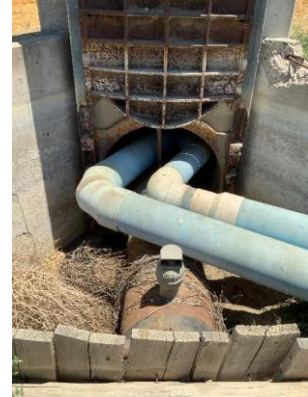
Photo 1 of 1 : UCIP_FA_2022_71147_103942.jpg

Comment Code					
Inspector Comment					
DS_ID:19882 FS_ID:71147 EP_NO: N/A Repair Type: Non-Urgent EVAL Issue: 10, Unauthorized Modification or Non-Compliant Permit Crossing Status: Found UCIP Comments: 06/24/2021 The record remains Non-Urgent. Altered crossing -- Two 12" plastic pipes going through LS outlet, recommend removing before flood season. No permit was found authorizing this encroachment. CVFPB will need to review crossing to determine owner. The UCIP inspection was completed with GEI staff, H.Dunn. (P.Espinoza – GEI) 04/10/2014 Altered crossing--steel pipe section on landward side and concrete pipe section on waterward side. Joints on waterward side separated. Need to contact owner to determine status. (O. Magana - DWR UCIP) FIELD_STRUCT_DESC: [Rodunder Siphon] 48-inch reinforced concrete pipe (RCP) irrigation siphon through the levee, 14.5 feet below the crown. Concrete U-shaped headwall on the outlet structure on the landside (LS) end. Slide gate mounted on the headwall. [Additional Reference(s): DWR Levee Log, 2002, (HLM 30.26). USACE San Joaquin O&M Manual, Unit No. 601, Part No. 1, 1967, Amended in 1978, Revised 20 June 1985, (HLM 30.27). DWR As-Built Specification No. 64-01, Sheet No. 11, 6 November 1963, (HLM 30.27)]. FS Date: 6/24/2021 10:15:00 AM

LS view: Closeup of slide gate and unauthorized 12" pipes going through outlet pipe at toe, 1 of 2 photos.

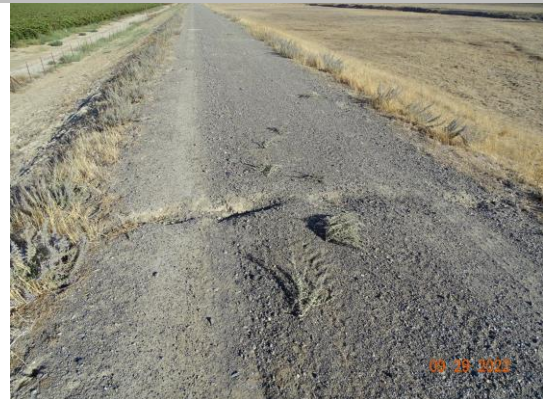
Photo 1 of 1 : FA_2022_NA0010_124_139_20221012_00253.jpg

LM Start	30.79	Rating **	M	Issue No.	139
LM End	30.79	Issue Type +	Ma	Location *	CR
Category	Earthen Levee			GPS Latitude/Longitude	
				Start	End
Item	Animal Control			37.021804 °	37.021804 °
				-120.437703 °	-120.437703 °
DWR ID	DWR_NA0010_06_f_2022_139				
Comment Code					
A3 : No rodents visible, but rodent burrows visible; need to backfill and compact or grout burrows.					
Inspector Comment					
Collapsed rodent burrow has created a few depressions in the crown at this location.

Depression in the levee crown. (Fall 2022)

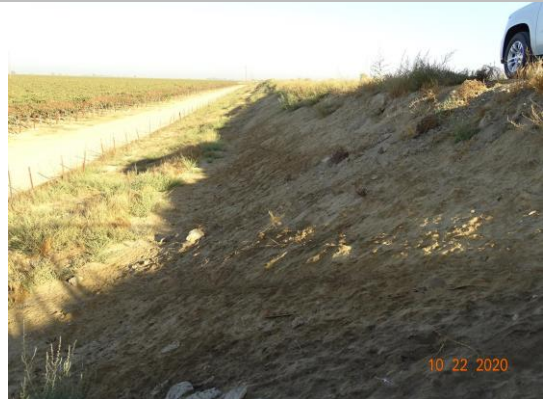
Photo 1 of 1 : FA_2022_NA0010_124_1207_20220822_00061.jpg

LM Start	30.81	Rating **	M	Issue No.	1207
LM End	31.06	Issue Type +	Ma	Location *	LS
Category	Earthen Levee			GPS Latitude/Longitude	
				Start	End
Item	Erosion / Livestock			37.021615 °	37.018428 °
				-120.437587 °	-120.435378 °
DWR ID	DWR_NA0010_06_s_2015_1207				
Comment Code					
E4 : Repair the levee slope damaged by livestock and prevent large animal access.					
Inspector Comment					
Landside erosion greater than 1" in depth and greater than 3" in length. Erosion is caused by livestock traffic.

Looking upstream at livestock damage to the landside slope. (Fall 2020)

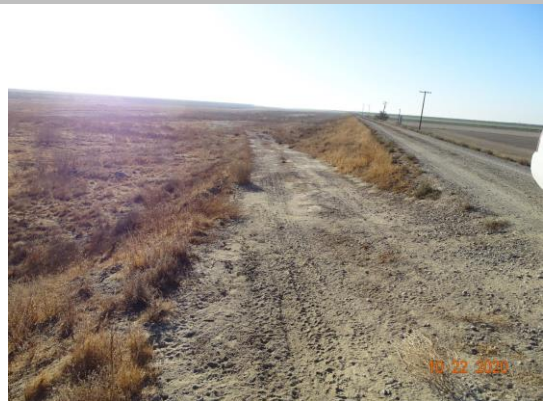
Photo 1 of 1 : FA_2022_NA0010_124_80_20220822_00016.jpg

LM Start	31.10	Rating **	U	Issue No.	80
LM End	31.10	Issue Type +	En	Location *	WS
Category	Earthen Levee			GPS Latitude/Longitude	
				Start	End
Item	Encroachments			37.017907 °	37.017907 °
				-120.434970 °	-120.434970 °
DWR ID	DWR_NA0010_06_s_2017_80				
Comment Code					
RA : Ramp					
Inspector Comment					
Farmer installed ramp on waterside slope.

Looking upstream at ramp on the waterside slope. (Fall 2020)

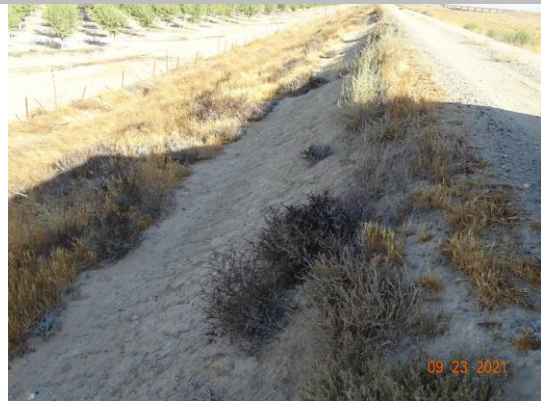
Photo 1 of 1 : FA_2022_NA0010_124_108_20220822_00033.jpg

LM Start	31.50	Rating **	M	Issue No.	108
LM End	31.70	Issue Type +	Ma	Location *	LS
Category	Earthen Levee			GPS Latitude/Longitude	
				Start	End
Item	Erosion / Livestock			37.012830 °	37.010335 °
				-120.431523 °	-120.429817 °
DWR ID	DWR_NA0010_06_f _ 2021_108				
Comment Code					
E4 : Repair the levee slope damaged by livestock and prevent large animal access.					
Inspector Comment

View of the landside slope looking downstream. (Fall 2021)

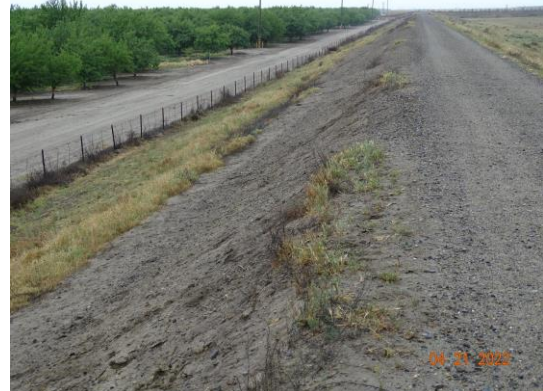
Photo 1 of 1 : FA_2022_NA0010_124_129_20220822_00047.jpg

LM Start	32.37	Rating **	U	Issue No.	129
LM End	32.88	Issue Type +	Ma	Location *	LS
Category	Earthen Levee			GPS Latitude/Longitude	
				Start	End
Item	Erosion / Livestock			37.003251 °	36.997745 °
				-120.421556 °	-120.415197 °
DWR ID	DWR_NA0010_06_s_2022_129				
Comment Code					
E4 : Repair the levee slope damaged by livestock and prevent large animal access.					
Inspector Comment					
Slope damage from livestock. Damage is beginning to erode into levee crown.

Erosion from livestock activity along the landside slope. (Spring 2022)

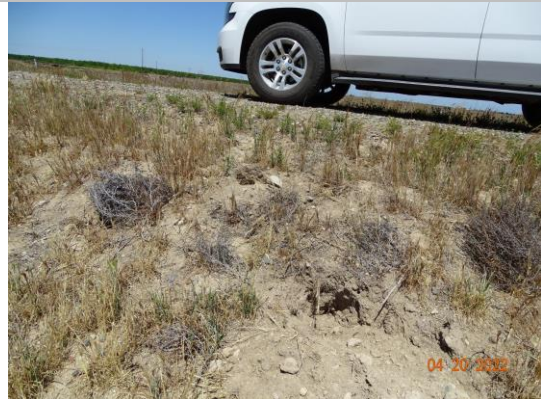
Photo 1 of 1 : FA_2022_NA0010_124_130_20220822_00048.jpg

LM Start	35.51	Rating **	M	Issue No.	130
LM End	35.51	Issue Type +	Ma	Location *	LS
Category	Earthen Levee			GPS Latitude/Longitude	
				Start	End
Item	Animal Control			36.974349 °	36.974349 °
				-120.380584 °	-120.380584 °
DWR ID	DWR_NA0010_06_s_ 2022_130				
Comment Code					
A3 : No rodents visible, but rodent burrows visible; need to backfill and compact or grout burrows.					
Inspector Comment

Representative view of rodent burrows in the landside slope. (Spring 2022)

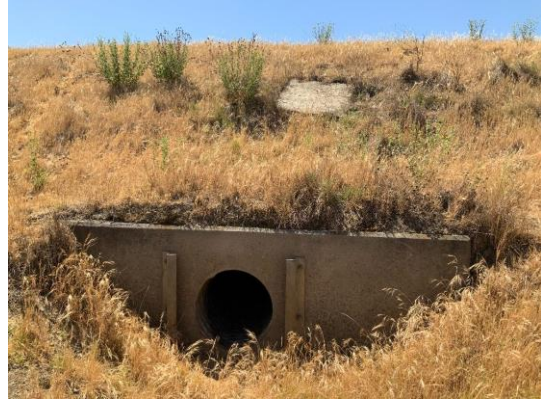
Photo 1 of 3 : UCIP_FA_2022_71165_99441.jpg

DS_ID:19892
FS_ID:71165
EP_NO: N/A
Repair Type: Non-Urgent
EVAL Issue:
Crossing Status: Found
UCIP Comments: 06/2/2021 Record remains Non-Urgent. DWR DMP internal inspection has not found pipe integrity issues. LOF of crossing is less or equal to 4.0. Recommend next video inspection in 5 years. No permit was found authorizing this encroachment. CVFPB will need to review crossing to determine owner. The UCIP inspection was completed with GEI staff, P. Espinoza. (H. Dunn – GEI) 07/20/2016 Inlet blocked off by wooden board. Dense vegetation limits the inspector's visibility to identify signs of pipe failure (leaks) along WS and LS. Crossing downgraded from Urgent to Non-Urgent. (O. Magana - DWR UCIP)04/15/2014 Flapgate partially blocked by soil buildup at WS toe. (W. Wylie - DWR UCIP)
FIELD_STRUCT_DESC: 24-inch corrugated metal gravity drainage pipe (CMP) through the levee, 10.8 feet below the crown. Flap gate on the waterside (WS) end. Concrete headwall on the landside (LS) end. Concrete U-shaped headwall on the WS end. [Additional Reference(s): DWR Levee Log, 2002, (HLM 0.08). USACE San Joaquin O&M Manual, Unit No. 601, Part No. 1, 1967, Amended in 1978, Revised 20 June 1985, (HLM 0.07). DWR As-Built Specification No. 63-25, Sheet No. 11, 9 May 1963, (HLM 0.07)].

LS view: Slope and headwall at toe.

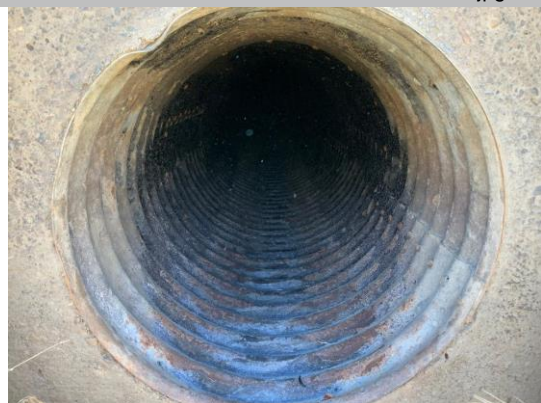
Photo 2 of 3 : UCIP_FA_2022_71165_99442.jpg

LS view: Close up of pipe inlet at toe.

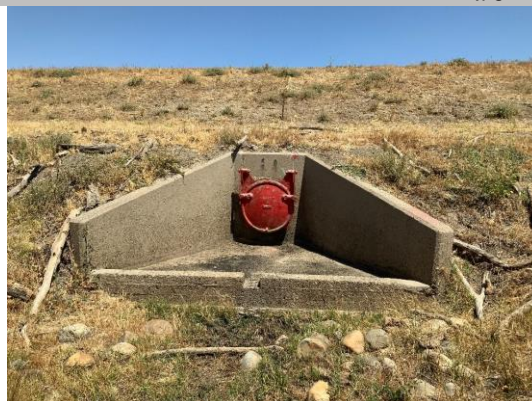
Photo 3 of 3 : UCIP_FA_2022_71165_99438.jpg

WS view: Slope, headwall, and flapgate at toe.

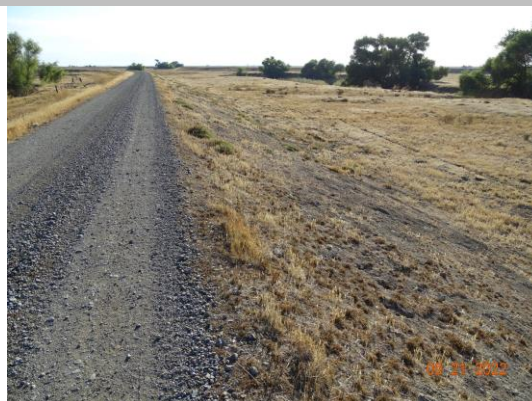
Photo 1 of 1 : FA_2022_NA0010_125_15_20221012_00042.jpg

LM Start	0.08	Rating **	A	Issue No.	15
LM End	0.08	Issue Type +	Ma	Location *	WS
Category	Earthen Levee			GPS Latitude/Longitude	
				Start	End
Item	Vegetation			37.255929 °	37.255929 °
				-120.771005 °	-120.771005 °
DWR ID	DWR_NA0010_07_f_2022_15				
Comment Code					
V1 : Control annual grass and weeds on the levee slopes and easements.					
Inspector Comment					
The annual vegetation is well maintained.

View of vegetation management on the waterside slope. (Fall 2022)

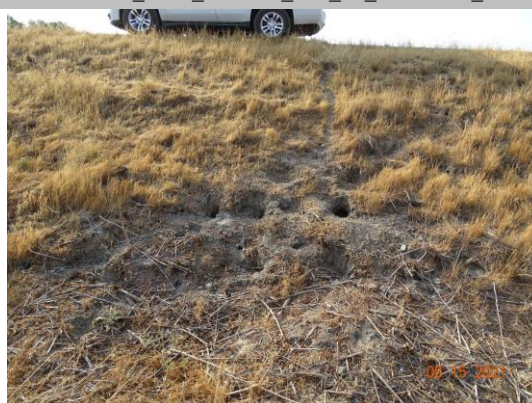
Photo 1 of 1 : FA_2022_NA0010_125_17_20220822_00004.jpg

LM Start	0.10	Rating **	M	Issue No.	17
LM End	0.10	Issue Type +	Ma	Location *	LS
Category	Earthen Levee			GPS Latitude/Longitude	
				Start	End
Item	Animal Control			37.256017 °	37.256017 °
				-120.770636 °	-120.770636 °
DWR ID	DWR_NA0010_07_f_2021_17				
Comment Code					
A3 : No rodents visible, but rodent burrows visible; need to backfill and compact or grout burrows.					
Inspector Comment

View of rodent holes in the landside slope. (Fall 2021)

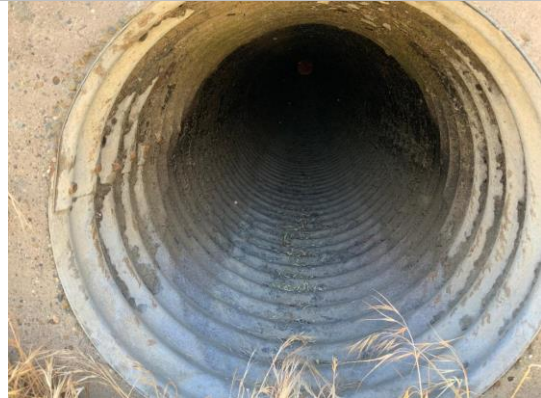
Photo 2 of 3 : UCIP_FA_2022_71166_99443.jpg

LS view: Close up of pipe inlet at toe.

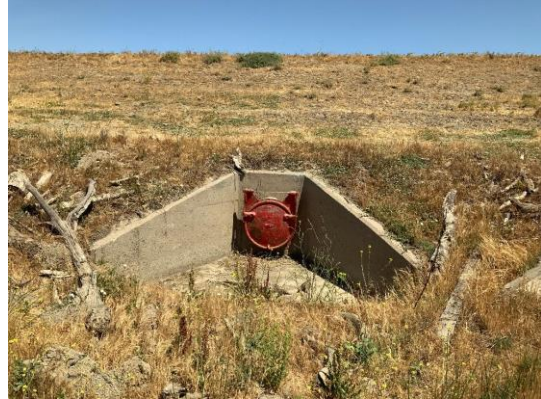
Photo 3 of 3 : UCIP_FA_2022_71166_99445.jpg

WS view: Slope, headwall, and flapgate at toe.

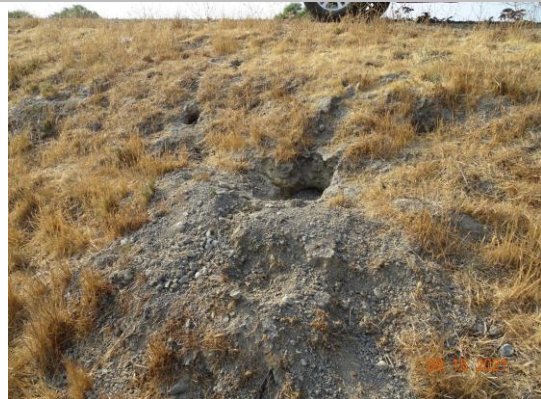
Photo 1 of 1 : FA_2022_NA0010_125_29_20220822_00011.jpg

LM Start	0.40	Rating **	M	Issue No.	29
LM End	0.50	Issue Type +	Ma	Location *	LS
Category	Earthen Levee			GPS Latitude/Longitude	
				Start	End
Item	Animal Control			37.257786 °	37.258722 °
				-120.765855 °	-120.764867 °
DWR ID	DWR_NA0010_07_s_2012_29				
Comment Code					
A3 : No rodents visible, but rodent burrows visible; need to backfill and compact or grout burrows.					
Inspector Comment					
Several rodent holes were noted on the landside and waterside slope and shoulder.

Looking at representative rodent hole in the landside slope. (Fall 2021)

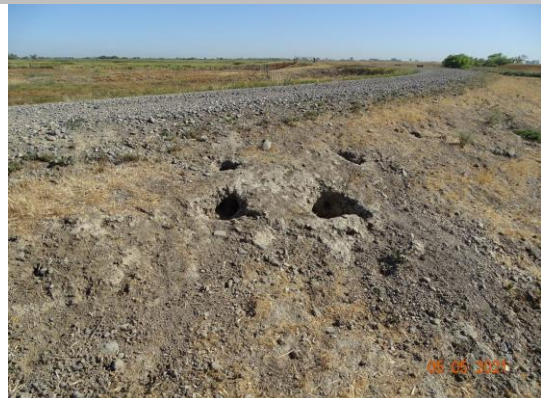
Photo 1 of 1 : FA_2022_NA0010_125_22_20220822_00008.jpg

LM Start	0.44	Rating **	M	Issue No.	22
LM End	0.44	Issue Type +	Ma	Location *	WS
Category	Earthen Levee			GPS Latitude/Longitude	
				Start	End
Item	Animal Control			37.257894 °	37.257894 °
				-120.765231 °	-120.765231 °
DWR ID	DWR_NA0010_07_s_2021_22				
Comment Code					
A3 : No rodents visible, but rodent burrows visible; need to backfill and compact or grout burrows.					
Inspector Comment

View of rodent burrows in the waterside slope and shoulder. (Spring 2021)

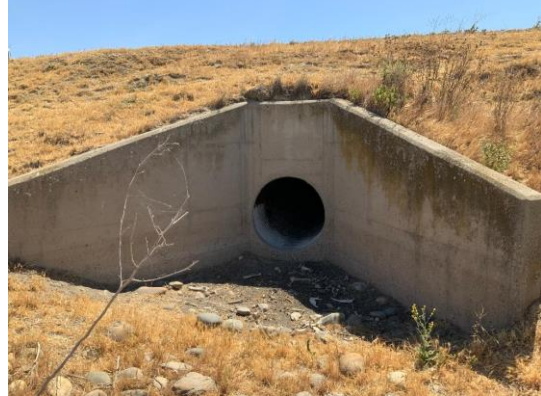
Photo 1 of 3 : UCIP_FA_2022_71167_99450.jpg

Comment Code						
Inspector Comment						
DS_ID:19894 FS_ID:71167 EP_NO: N/A Repair Type: Non-Urgent EVAL Issue: 4b, Safety Issue Crossing Status: Found UCIP Comments: 06/2/2021 Record remains Non-Urgent. No cover over the WS metal riser. There is debris and wood pallets within the riser that may prevent the ability for the slidegate to be opened or water to flow through, recommend cleaning out. DWR DMP internal inspection has not found pipe integrity issues. LOF of crossing is less or equal to 4.0. Recommend next video inspection in 5 years. No permit was found authorizing this encroachment. CVFPB will need to review crossing to determine owner. The UCIP inspection was completed with GEI staff, P. Espinoza. (H. Dunn – GEI) 04/15/2014 Slide gate not operable, but left in closed position. Need to reinstall covers over slide gate standpipe. (W. Wylie - DWR UCIP) FIELD_STRUCT_DESC: 36-inch corrugated metal gravity drainage pipe (CMP) through the levee, 9.7 feet below the crown. Slide gate in a 48-inch CMP riser unit on the landside (LS) slope. Concrete U-shaped headwall on the LS end. Inlet channel cobble revetted. Dilapidated wooden pier on the waterside (WS). WS slope and outlet ditch cobble revetted. [Additional Reference(s): DWR Levee Log, 2002, (HLM 0.49). USACE San Joaquin O&M Manual, Unit No. 601, Part No. 1, 1967, Amended in 1978, Revised 20 June 1985, (HLM 0.49). DWR As-Built Specification No. 63-25, Sheet No. 11, 9 May 1963, (HLM 0.49)]. FS Date: 6/2/2021

LS view: Slope and headwall at toe.

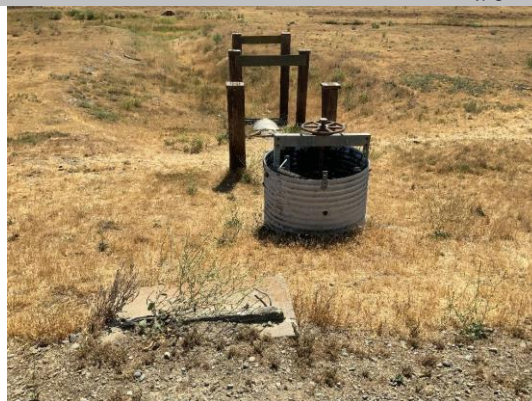
Photo 2 of 3 : UCIP_FA_2022_71167_99453.jpg

WS view: Slope with metal riser and slidegate from crown.

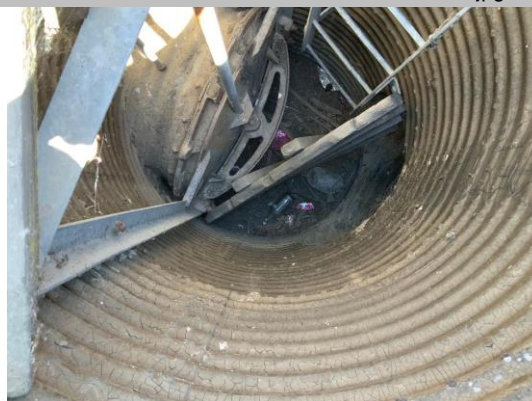
Photo 3 of 3 : UCIP_FA_2022_71167_99454.jpg

WS view: Close up of inside metal riser, wood pallets in the way.

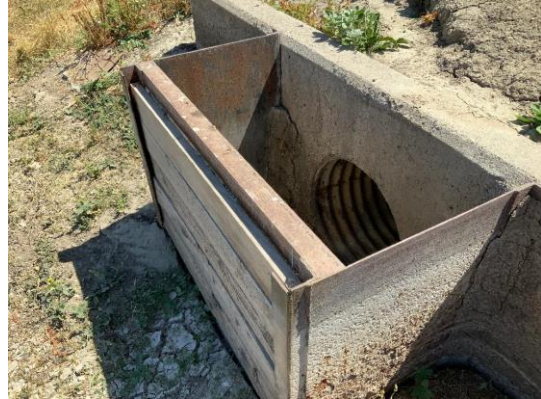
Photo 1 of 3 : UCIP_FA_2022_72517_99457.jpg

DS_ID:19895
FS_ID:72517
EP_NO: N/A
Repair Type: Urgent
EVAL Issue: 3a, Flood Risk
Crossing Status: Found
UCIP Comments: 06/2/2021 The record has been upgraded from No Action Needed to Urgent. DWR DMP internal inspection has not found pipe integrity issues. LOF of crossing is less or equal to 4.0. Recommend next video inspection in 5 years. There are plywood barriers on both WS and LS pipe ends, but no flapgate on either, and flapgate removed on WS. No permit was found authorizing this encroachment. CVFPB will need to review crossing to determine owner. The UCIP inspection was completed with GEI staff, P. Espinoza. (H. Dunn – GEI)
FIELD_STRUCT_DESC: 24-inch corrugated metal gravity drainage pipe (CMP) through the levee, 9.0 feet below the crown. Flap gate on the waterside (WS) end. Concrete headwall with a wooden weir at the inlet on the landside (LS) toe. Concrete U-shaped headwall on the WS toe. [Additional Reference(s): DWR Levee Log, 2002, (HLM 0.53). USACE San Joaquin O&M Manual, Unit No. 601, Part No. 1, 1967, Amended in 1978, Revised 20 June 1985, (HLM 0.53). DWR As-Built Specification No. 63-25, Sheet No. 11, 9 May 1963, (HLM 0.53)].

LS view: Close up of plywood barrier at toe.

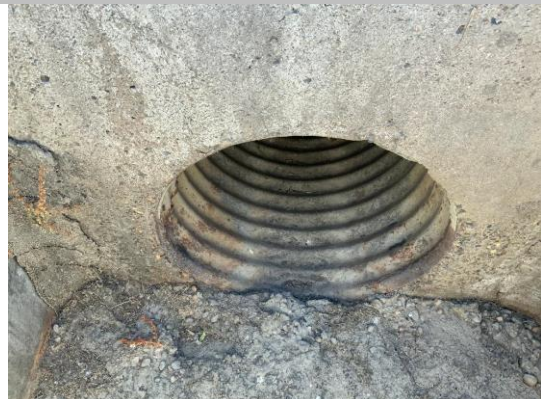
Photo 2 of 3 : UCIP_FA_2022_72517_99458.jpg

LS view: Close up of pipe inlet at toe.

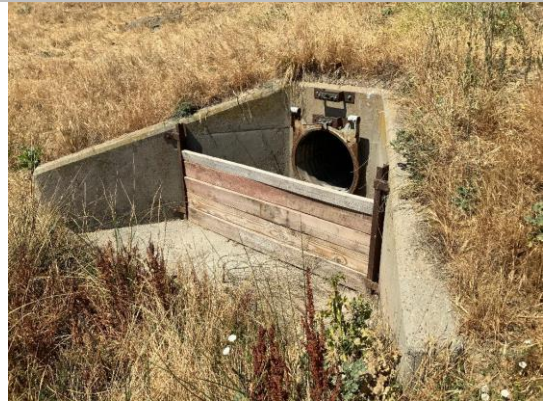
Photo 3 of 3 : UCIP_FA_2022_72517_99463.jpg

WS view: Close up of plywood barrier with no flapgate.

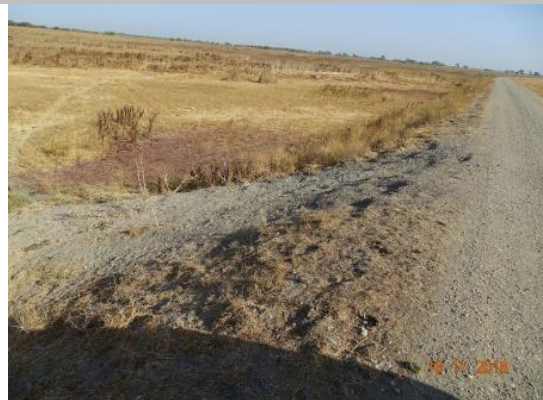
Photo 1 of 1 : FA_2022_NA0010_125_19_20220822_00006.jpg

LM Start	0.70	Rating **	A/W	Issue No.	19
LM End	0.70	Issue Type +	Ma	Location *	LS
Category	Earthen Levee			GPS Latitude/Longitude	
				Start	End
Item	Erosion / Livestock			37.261337 °	37.261337 °
				-120.763303 °	-120.763303 °
DWR ID	DWR_NA0010_07_f_2018_19				
Comment Code					
E4 : Repair the levee slope damaged by livestock and prevent large animal access.					
Inspector Comment					
There is livestock damage to the landside slope but the levee integrity is not compromised. Continue to monitor.

Damage to landside slope from livestock. (Fall 2018)

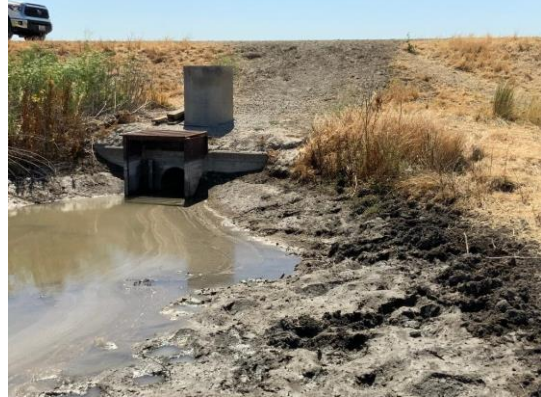
Photo 1 of 3 : UCIP_FA_2022_71169_99465.jpg

Comment Code						
Inspector Comment						
DS_ID:19896 FS_ID:71169 EP_NO: N/A Repair Type: Non-Urgent EVAL Issue: Crossing Status: Found UCIP Comments: 06/2/2021 Record remains Non-Urgent. No permit was found authorizing this encroachment. CVFPB will need to review crossing to determine owner. Limited inspection due to water flowing through the pipe during inspection. At the time of inspection, the wooden flashboards were not in place on the LS end. The UCIP inspection was completed with GEI staff, P. Espinoza. (H. Dunn – GEI) 04/15/2014 Need to contact owner. Heavy sediment buildup at inlet due to animal activity should be cleared. (W. Wylie - DWR UCIP) FIELD_STRUCT_DESC: 24-inch corrugated metal gravity drainage pipe (CMP) through the levee, 9.8 feet below the crown. Flap gate on the waterside (WS) end. Wooden weir on a concrete headwall at the landside (LS) toe. 36-inch concrete riser unit at the LS toe. Concrete U-shaped headwall on the WS end. Concrete standpipe on the LS. [Additional Reference(s): DWR Levee Log, 2002, (HLM 0.86). USACE San Joaquin O&M Manual, Unit No. 601, Part No. 1, 1967, Amended in 1978, Revised 20 June 1985, (HLM 0.85). DWR As-Built Specification No. 63-25, Sheet No. 11, 9 May 1963, (HLM 0.85)]. FS Date: 6/2/2021

LS view: Slope and riser visible at toe.

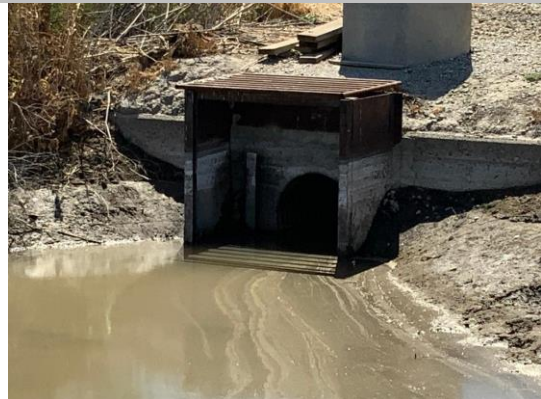
Photo 2 of 3 : UCIP_FA_2022_71169_99466.jpg

LS view: Close up of pipe inlet at toe.

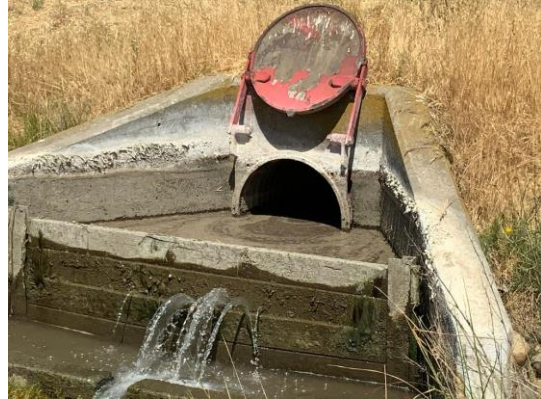
Photo 3 of 3 : UCIP_FA_2022_71169_99470.jpg

WS view: Close up of flapgate at toe.

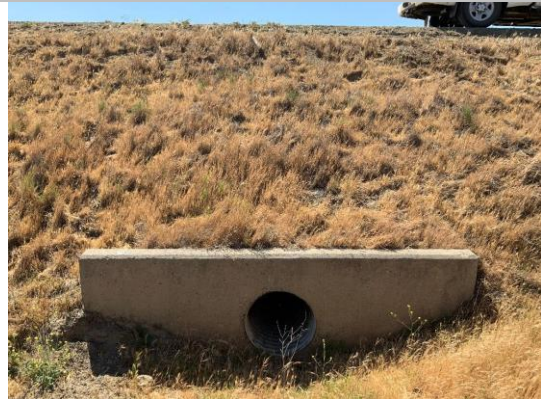
Photo 1 of 3 : UCIP_FA_2022_71170_99472.jpg

DS_ID:19897
 FS_ID:71170
 EP_NO: N/A
 Repair Type: Non-Urgent
 EVAL Issue:
 Crossing Status: Found
 UCIP Comments: 06/2/2021 The record has been upgraded from No Action Needed to Non-Urgent. DWR DMP internal inspection has not found pipe integrity issues. LOF of crossing is less or equal to 4.0. Recommend next video inspection in 5 years. No permit was found authorizing this encroachment. CVFPB will need to review crossing to determine owner. The UCIP inspection was completed with GEI staff, P. Espinoza. (H. Dunn – GEI)
 FIELD_STRUCT_DESC: 24-inch corrugated metal gravity drainage pipe (CMP) through the levee, 11.5 feet below the crown. Flap gate on the waterside (WS) end. Concrete headwall on the landside (LS) end. Concrete U-shaped headwall on the WS end. [Additional Reference(s): DWR Levee Log, 2002, (HLM 0.94). USACE San Joaquin O&M Manual, Unit No. 601, Part No. 1, 1967, Amended in 1978, Revised 20 June 1985, (HLM 0.94). DWR As-Built Specification No. 63-25, Sheet No. 11, 9 May 1963, (HLM 0.94)].

LS view: Slope and headwall at toe.

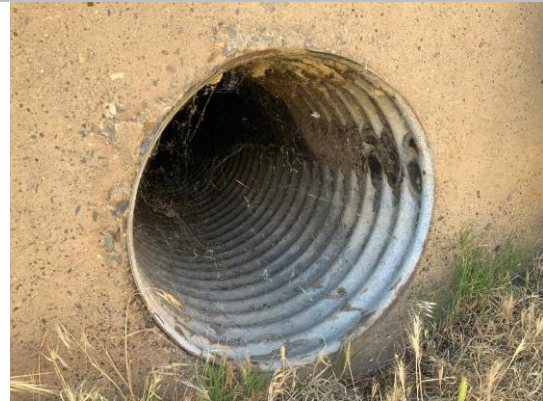
Photo 2 of 3 : UCIP_FA_2022_71170_99473.jpg

LS view: Close up of pipe inlet.

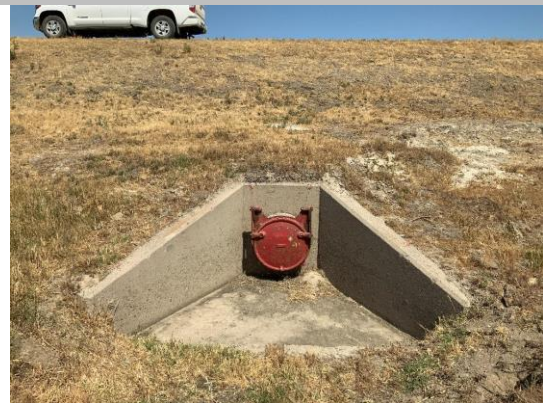
Photo 3 of 3 : UCIP_FA_2022_71170_99476.jpg

WS view: Slope, headwall, and flapgate at toe.

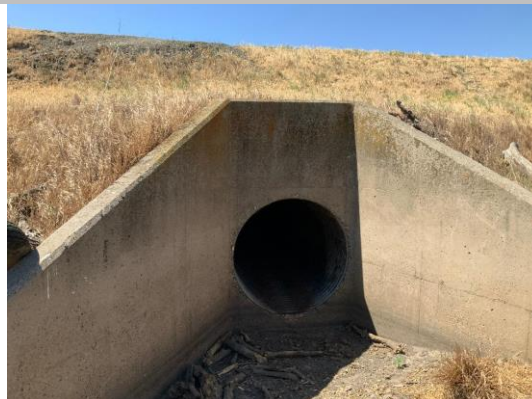
Photo 1 of 3 : UCIP_FA_2022_71171_99483.jpg

DS_ID:19898
FS_ID:71171
EP_NO: N/A
Repair Type: Non-Urgent
EVAL Issue:
Crossing Status: Found
UCIP Comments: 06/2/2021 The record has been upgraded from No Action Needed to Non-Urgent. No permit was found authorizing this encroachment. CVFPB will need to review crossing to determine owner. The UCIP inspection was completed with GEI staff, P. Espinoza. (H. Dunn – GEI)
FIELD_STRUCT_DESC: 48-inch corrugated metal gravity drainage pipe (CMP) through the levee, 14.6 feet below the crown. Flap gate on the waterside (WS) end. Concrete U-shaped headwall on each end. [Additional Reference(s): DWR Levee Log, 2002, (HLM 1.17). USACE San Joaquin O&M Manual, Unit No. 601, Part No. 1, 1967, Amended in 1978, Revised 20 June 1985, (HLM 1.17). DWR As-Built Specification No. 63-25, Sheet No. 11, 9 May 1963, (HLM 1.17)].
FS Date: 6/2/2021

LS view: Slope and headwall at toe.

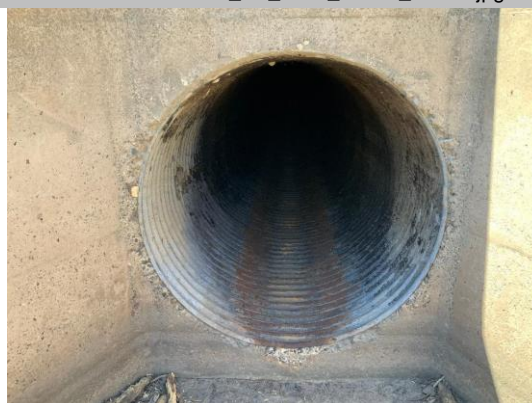
Photo 2 of 3 : UCIP_FA_2022_71171_99484.jpg

LS view: Close up of pipe inlet at toe.

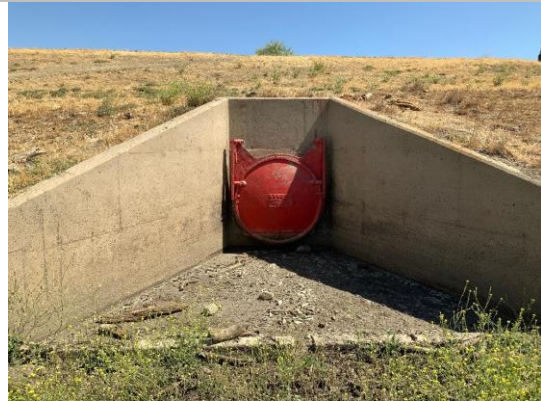
Photo 3 of 3 : UCIP_FA_2022_71171_99479.jpg

WS view: Slope, headwall, and flapgate at toe.

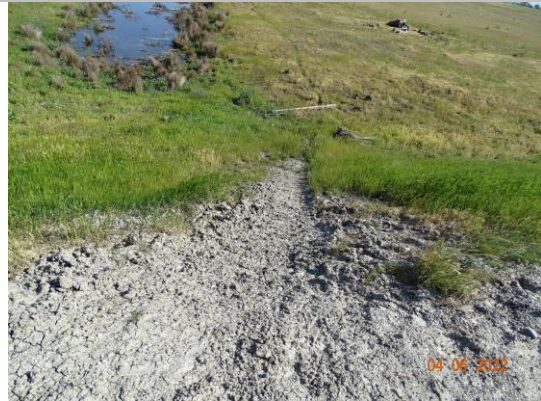
Photo 1 of 1 : FA_2022_NA0010_125_25_20220822_00010.jpg

LM Start	1.24	Rating **	A/W	Issue No.	25
LM End	1.24	Issue Type +	Ma	Location *	LS
Category	Earthen Levee			GPS Latitude/Longitude	
				Start	End
Item	Erosion / Livestock			37.264365 °	37.264365 °
				-120.755358 °	-120.755358 °
DWR ID	DWR_NA0010_07_s_2022_25				
Comment Code					
E4 : Repair the levee slope damaged by livestock and prevent large animal access.					
Inspector Comment

Looking down the landside slope at erosion from livestock traffic. (Spring 2022)

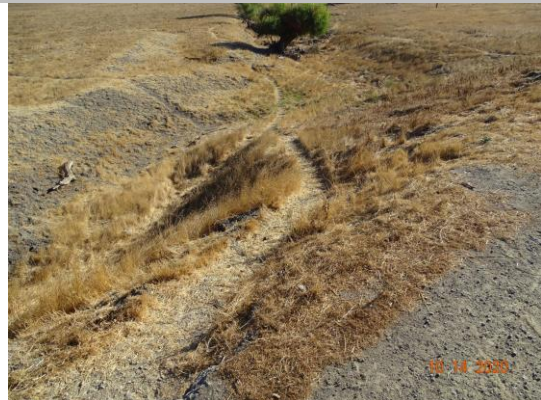
Photo 1 of 1 : FA_2022_NA0010_125_16_20220822_00003.jpg

LM Start	1.49	Rating **	A/W	Issue No.	16
LM End	1.49	Issue Type +	Ma	Location *	LS
Category	Earthen Levee			GPS Latitude/Longitude	
				Start	End
Item	Erosion / Livestock			37.263999 °	37.263999 °
				-120.750854 °	-120.750854 °
DWR ID	DWR_NA0010_07_f _ 2017_16				
Comment Code					
E4 : Repair the levee slope damaged by livestock and prevent large animal access.					
Inspector Comment					
Monitor the slope damaged by animal traffic.

Cattle trail on the landside slope. (Fall 2020)

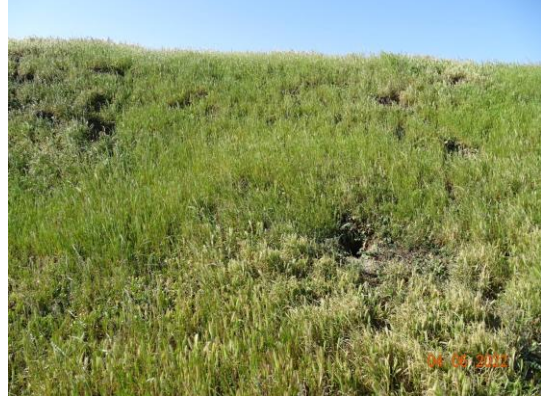
Photo 1 of 1 : FA_2022_NA0010_125_6_20220822_00001.jpg

LM Start	1.50	Rating **	M	Issue No.	6
LM End	1.51	Issue Type +	Ma	Location *	LS
Category	Earthen Levee			GPS Latitude/Longitude	
				Start	End
Item	Animal Control			37.263955 °	37.263885 °
				-120.750751 °	-120.750527 °
DWR ID	DWR_NA0010_07_s_2014_6				
Comment Code					
A1 : Exterminate rodents and backfill and compact or grout burrows.					
Inspector Comment

View of rodent holes on the landside slope. (Spring 2022)

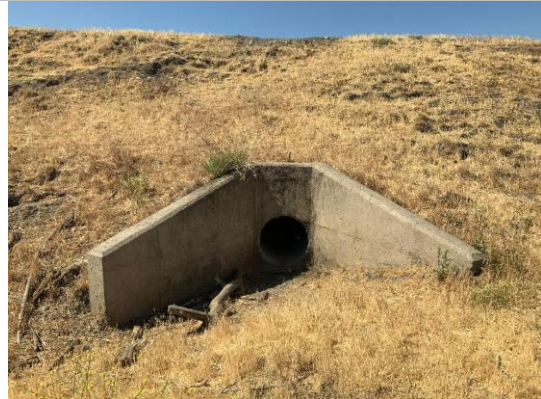
Photo 1 of 3 : UCIP_FA_2022_71172_99486.jpg

LS view: Slope and headwall at toe.

DS_ID:19902
 FS_ID:71172
 EP_NO: N/A
 Repair Type: Non-Urgent
 EVAL Issue:
 Crossing Status: Found
 UCIP Comments: 06/2/2021 The record has been upgraded from No Action Needed to Non-Urgent. DWR DMP internal inspection has not found pipe integrity issues. LOF of crossing is less or equal to 4.0. Recommend next video inspection in 5 years. No permit was found authorizing this encroachment. CVFPB will need to review crossing to determine owner. The UCIP inspection was completed with GEI staff, P. Espinoza. (H. Dunn – GEI)
 FIELD_STRUCT_DESC: 24-inch corrugated metal gravity drainage pipe (CMP) through the levee, 14.0 feet below the crown. Flap gate on the waterside (WS) end. Concrete U-shaped headwall on each end.
 [Additional Reference(s): DWR Levee Log, 2002, (HLM 1.51). USACE San Joaquin O&M Manual, Unit No. 601, Part No. 1, 1967, Amended in 1978, Revised 20 June 1985, (HLM 1.51). DWR As-Built Specification No. 63-25, Sheet No. 12, 9 May 1963, (HLM 1.51)].

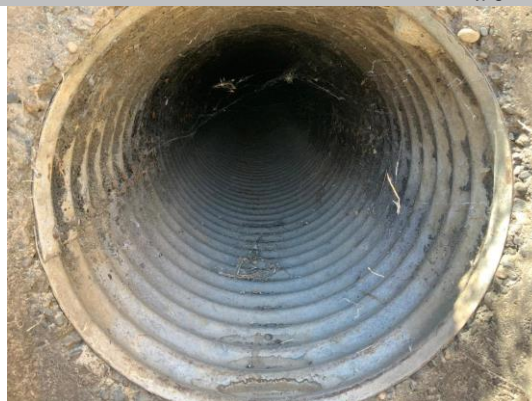
Photo 2 of 3 : UCIP_FA_2022_71172_99487.jpg

LS view: Close up of pipe inlet at toe.

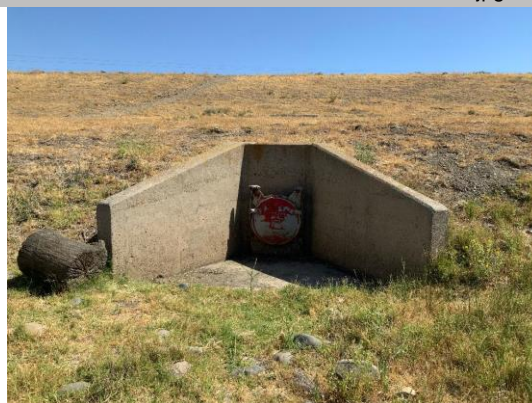
Photo 3 of 3 : UCIP_FA_2022_71172_99489.jpg

WS view: Slope, headwall, and flapgate at toe.

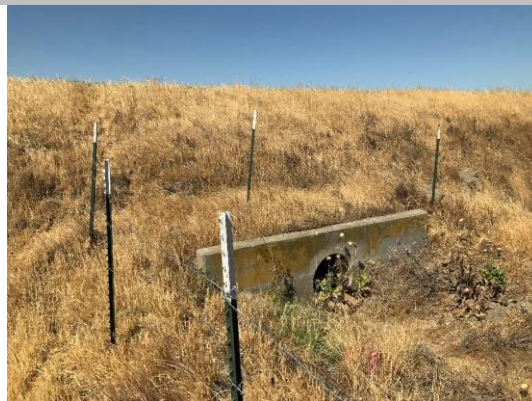
Photo 1 of 3 : UCIP_FA_2022_71173_99499.jpg

Comment Code					
Inspector Comment					
DS_ID:19899 FS_ID:71173 EP_NO: N/A Repair Type: Non-Urgent EVAL Issue: Crossing Status: Found UCIP Comments: 06/2/2021 The record has been upgraded from No Action Needed to Non-Urgent. LS pipe end surrounded by barbed wire, could not inspect closely. Metal pipe and plastic riser with flowmeter off the LS toe. DWR DMP internal inspection has not found pipe integrity issues. LOF of crossing is less or equal to 4.0. Recommend next video inspection in 5 years. No permit was found authorizing this encroachment. CVFPB will need to review crossing to determine owner. The UCIP inspection was completed with GEI staff, P. Espinoza. (H. Dunn – GEI) FIELD_STRUCT_DESC: 24-inch corrugated metal gravity drainage pipe (CMP) through the levee, 9.5 feet below the crown. Flap gate on the waterside (WS) end. Concrete headwall on the landside (LS) end. Concrete U-shaped headwall on the WS end. [Additional Reference(s): DWR Levee Log, 2002, (HLM 2.49). USACE San Joaquin O&M Manual, Unit No. 601, Part No. 1, 1967, Amended in 1978, Revised 20 June 1985, (HLM 2.48). DWR As-Built Specification No. 63-25, Sheet No. 12, 9 May 1963, (HLM 2.48)]. FS Date: 6/2/2021

LS view: Slope and headwall at toe.

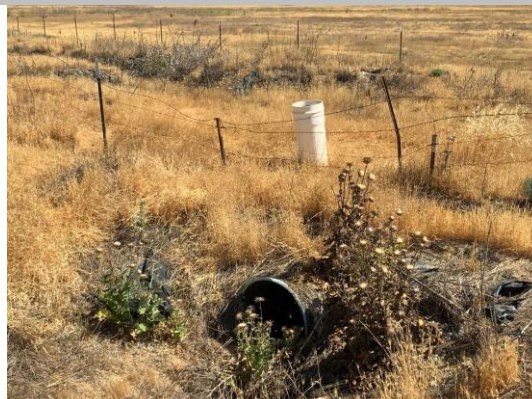
Photo 2 of 3 : UCIP_FA_2022_71173_99493.jpg

LS view: Pipe inlet and riser with flowmeter off toe.

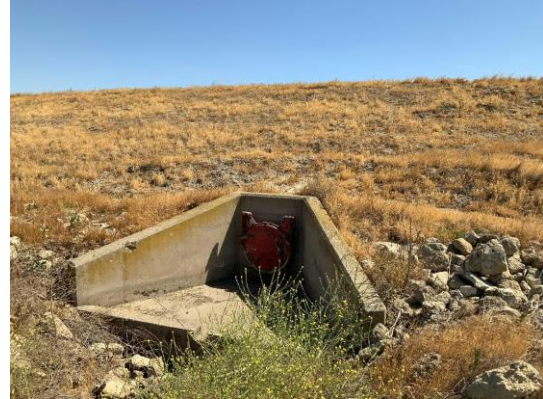
Photo 3 of 3 : UCIP_FA_2022_71173_99495.jpg

WS view: Slope, headwall, and flapgate at toe.

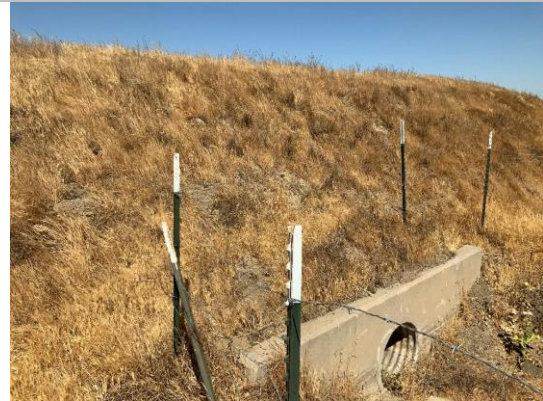
Photo 1 of 3 : UCIP_FA_2022_71174_99502.jpg

DS_ID:19900
 FS_ID:71174
 EP_NO: N/A
 Repair Type: Non-Urgent
 EVAL Issue:
 Crossing Status: Found
 UCIP Comments: 06/2/2021 The record has been upgraded from No Action Needed to Non-Urgent. LS pipe end surrounded by barbed wire, inspection was limited. No permit was found authorizing this encroachment. CVFPB will need to review crossing to determine owner. The UCIP inspection was completed with GEI staff, P. Espinoza. (H. Dunn – GEI)
 FIELD_STRUCT_DESC: 24-inch corrugated metal gravity drainage pipe (CMP) through the levee, 11.5 feet below the crown. Flap gate on the waterside (WS) end. Concrete headwall on the landside (LS) end. Concrete U-shaped headwall on the WS end. [Additional Reference(s): DWR Levee Log, 2002, (HLM 2.65). USACE San Joaquin O&M Manual, Unit No. 601, Part No. 1, 1967, Amended in 1978, Revised 20 June 1985, (HLM 2.64). DWR As-Built Specification No. 63-25, Sheet No. 12, 9 May 1963, (HLM 2.64)].

LS view: Slope and headwall at toe.

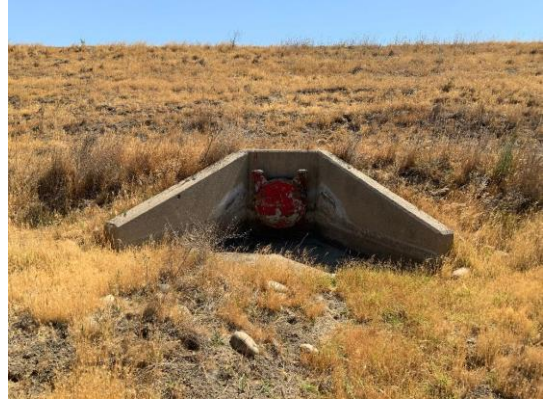
Photo 2 of 3 : UCIP_FA_2022_71174_99505.jpg

WS view: Slope, headwall, and flapgate at toe.

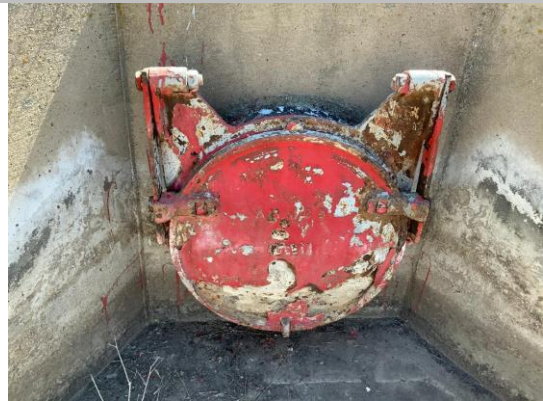
Photo 3 of 3 : UCIP_FA_2022_71174_99506.jpg

WS view: Close up of flapgate at toe.

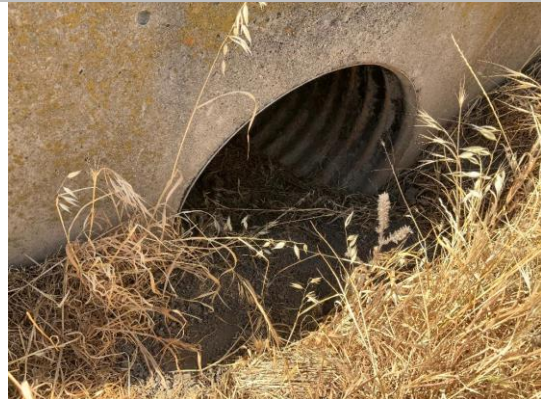
Photo 1 of 3 : UCIP_FA_2022_71175_99514.jpg

Comment Code						
Inspector Comment						
DS_ID:19901 FS_ID:71175 EP_NO: N/A Repair Type: Non-Urgent EVAL Issue: 5, Pipe Damage Crossing Status: Found UCIP Comments: 06/2/2021 Record remains Non-Urgent. DWR DMP internal inspection has found pipe integrity issues. LOF of crossing is equal to 4.1 and less than 5. Crossing will be monitored until funding becomes available for rehabilitation. Some sediment buildup in the inlet of the pipe on the LS, recommend cleaning out. No permit was found authorizing this encroachment. CVFPB will need to review crossing to determine owner. The UCIP inspection was completed with GEI staff, P. Espinoza. (H. Dunn – GEI) 04/15/2014 Some sediment buildup at landward toe and inside pipe--recommend clearing. (W. Wylie - DWR UCIP) FIELD_STRUCT_DESC: 24-inch corrugated metal gravity drainage pipe (CMP) through the levee, 10.4 feet below the crown. Flap gate on the waterside (WS) end. Concrete headwall on the landside (LS) end. Concrete U-shaped headwall on the WS end. [Additional Reference(s): DWR Levee Log, 2002, (HLM 3.09). USACE San Joaquin O&M Manual, Unit No. 601, Part No. 1, 1967, Amended in 1978, Revised 20 June 1985, (HLM 3.09). DWR As-Built Specification No. 63-25, Sheet No. 13, 9 May 1963, (HLM 3.09)]. FS Date: 6/2/2021

LS view: Close up of pipe inlet at toe.

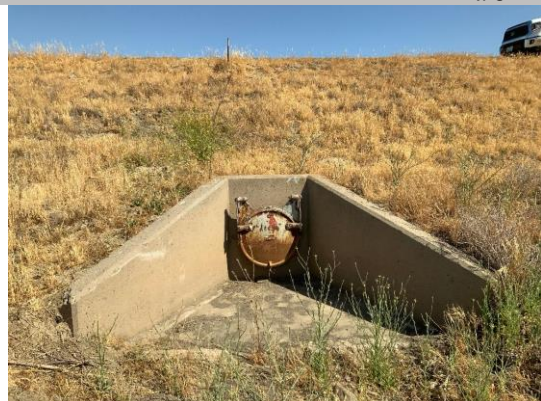
Photo 2 of 3 : UCIP_FA_2022_71175_99508.jpg

WS view: Slope, headwall, and flapgate at toe.

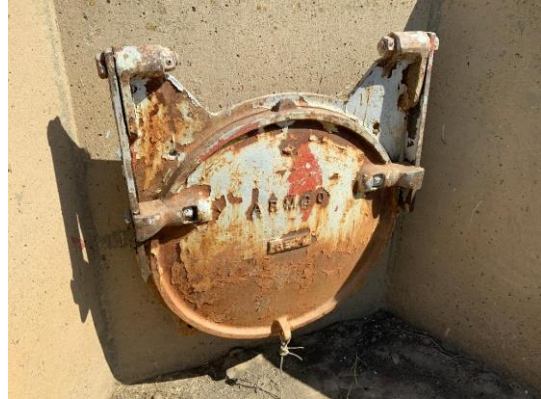
Photo 3 of 3 : UCIP_FA_2022_71175_99509.jpg

WS view: Close up of flapgate at toe.

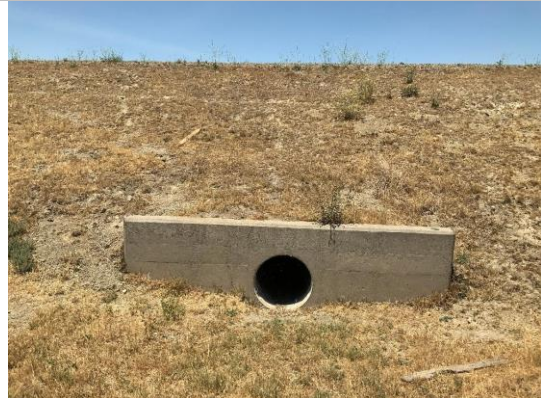
Photo 2 of 3 : UCIP_FA_2022_71177_99547.jpg

LS view: Slope and headwall at toe.

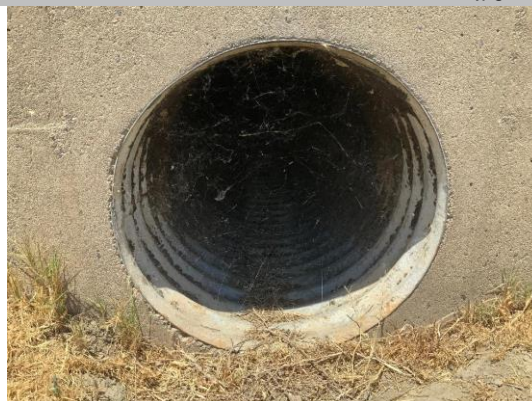
Photo 3 of 3 : UCIP_FA_2022_71177_99548.jpg

LS view: Close up of pipe inlet at toe.

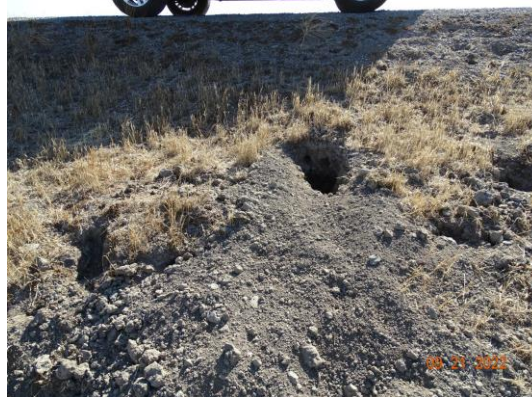
Photo 1 of 1 : FA_2022_NA0010_126_16_20221012_00045.jpg

LM Start	0.49	Rating **	U	Issue No.	16
LM End	0.49	Issue Type +	Ma	Location *	WS
Category	Earthen Levee			GPS Latitude/Longitude	
				Start	End
Item	Animal Control			37.257458 °	37.257458 °
				-120.763682 °	-120.763682 °
DWR ID	DWR_NA0010_08_f_2022_16				
Comment Code					
A3 : No rodents visible, but rodent burrows visible; need to backfill and compact or grout burrows.					
Inspector Comment

View of animal holes with large quantities of material displaced. (Fall 2022)

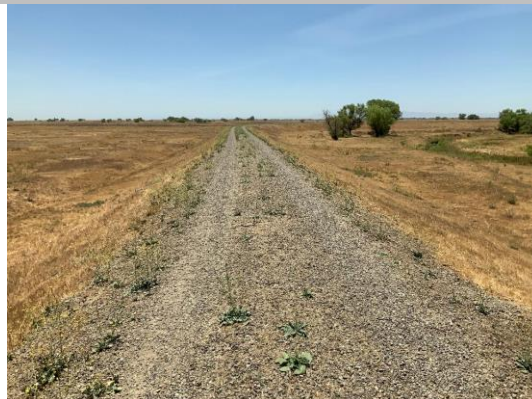
Photo 1 of 3 : UCIP_FA_2022_71178_99553.jpg

Comment Code					
Inspector Comment					
DS_ID:19904 FS_ID:71178 EP_NO: N/A Repair Type: Non-Urgent EVAL Issue: Crossing Status: Found UCIP Comments: 06/2/2021 The record has been upgraded from No Action Needed to Non-Urgent. DWR DMP internal inspection has not found pipe integrity issues. LOF of crossing is less or equal to 4.0. Recommend next video inspection in 5 years. No permit was found authorizing this encroachment. CVFPB will need to review crossing to determine owner. The UCIP inspection was completed with GEI staff, P. Espinoza. (H. Dunn – GEI) FIELD_STRUCT_DESC: 24-inch corrugated metal gravity drainage pipe (CMP) through the levee, 12.4 feet below the crown. Flap gate on the waterside (WS) end. Concrete headwall on each end. [Additional Reference(s): DWR Levee Log, 2002, (HLM 0.55). USACE San Joaquin O&M Manual, Unit No. 601, Part No. 1, 1967, Amended in 1978, Revised 20 June 1985, (HLM 0.57). DWR As-Built Specification No. 63-25, Sheet No. 11, 9 May 1963, (HLM 0.57)]. FS Date: 6/2/2021

Levee crown looking downstream.

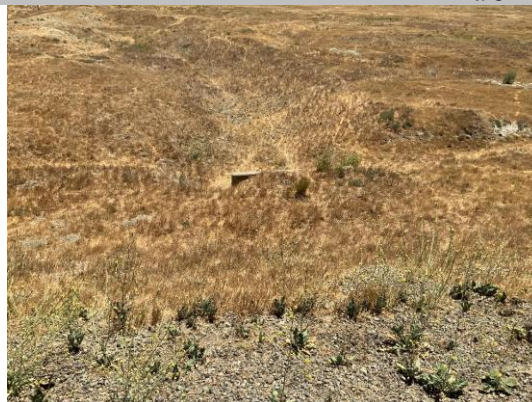
Photo 2 of 3 : UCIP_FA_2022_71178_99554.jpg

LS view: Headwall visible at toe from crown.

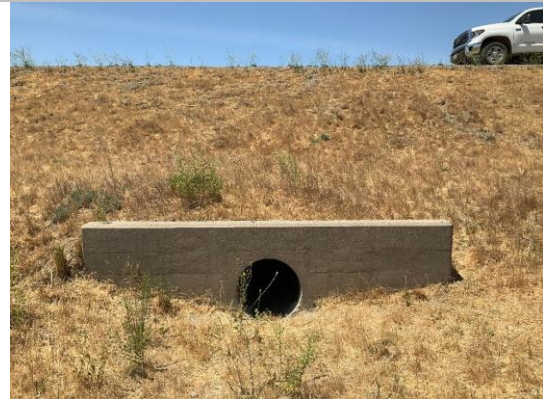
Photo 3 of 3 : UCIP_FA_2022_71178_99555.jpg

LS view: Slope and headwall at toe.
