Flood Control Project Maintenance Levee Inspections

Fall 2022 Levee Maintenance Deficiency Summary Report

San Joaquin River Basin

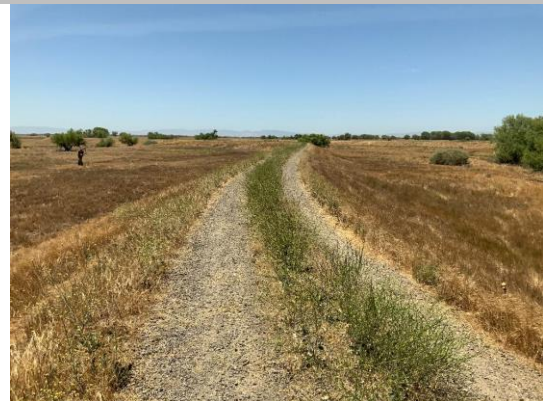
Photo 1 of 3 : UCIP_FA_2022_71179_99560.jpg

DS_ID:19905
 FS_ID:71179
 EP_NO: N/A
 Repair Type: Non-Urgent
 EVAL Issue:
 Crossing Status: Found
 UCIP Comments: 06/2/2021 The record has been upgraded from No Action Needed to Non-Urgent. DWR DMP internal inspection has not found pipe integrity issues. LOF of crossing is less or equal to 4.0. Recommend next video inspection in 5 years. No permit was found authorizing this encroachment. CVFPB will need to review crossing to determine owner. The UCIP inspection was completed with GEI staff, P. Espinoza. (H. Dunn – GEI)
 FIELD_STRUCT_DESC: 24-inch corrugated metal gravity drainage pipe (CMP) through the levee, 10.0 feet below the crown. Flap gate on the waterside (WS) end. Concrete headwall on each end. [Additional Reference(s): DWR Levee Log, 2002, (HLM 0.70). USACE San Joaquin O&M Manual, Unit No. 601, Part No. 1, 1967, Amended in 1978, Revised 20 June 1985, (HLM 0.72). DWR As-Built Specification No. 63-25, Sheet No. 11, 9 May 1963, (HLM 0.72)].

Levee crown looking downstream.

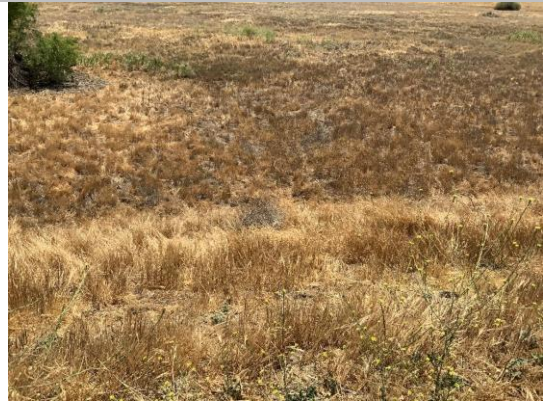
Photo 2 of 3 : UCIP_FA_2022_71179_99561.jpg

LS view: Toe from crown.

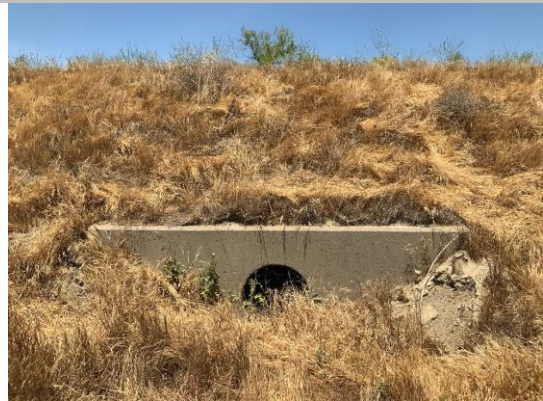
Photo 3 of 3 : UCIP_FA_2022_71179_99562.jpg

LS view: Slope and headwall at toe.

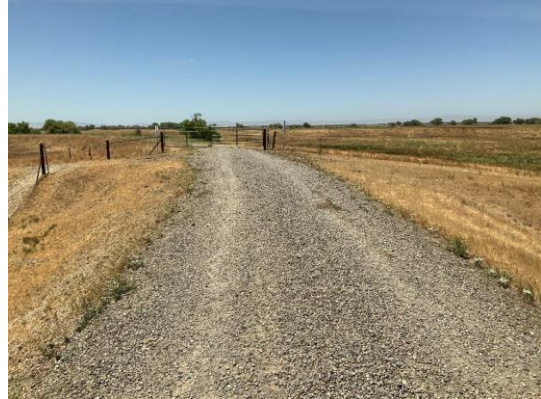
Photo 1 of 3 : UCIP_FA_2022_71180_99567.jpg

Comment Code						
Inspector Comment						
DS_ID:19832 FS_ID:71180 EP_NO: N/A Repair Type: Non-Urgent EVAL Issue: Crossing Status: Found UCIP Comments: 06/2/2021 Record remains Non-Urgent. DWR DMP internal inspection has not found pipe integrity issues. LOF of crossing is less or equal to 4.0. Recommend next video inspection in 5 years. No permit was found authorizing this encroachment. CVFPB will need to review crossing to determine owner. The UCIP inspection was completed with GEI staff, P. Espinoza. (H. Dunn – GEI) 04/16/2014 Some sediment buildup at inlet on LS toe. (W. Wylie - DWR UCIP) FIELD_STRUCT_DESC: 24-inch corrugated metal gravity drainage pipe (CMP) through the levee, 11.5 feet below the crown. Flap gate on the waterside (WS) end. Concrete headwall on each end. [Additional Reference(s): DWR Levee Log, 2002, (HLM 0.88). USACE San Joaquin O&M Manual, Unit No. 601, Part No. 1, 1967, Amended in 1978, Revised 20 June 1985, (HLM 0.89). DWR As-Built Specification No. 63-25, Sheet No. 11, 9 May 1963, (HLM 0.89)]. FS Date: 6/2/2021

Levee crown looking downstream.

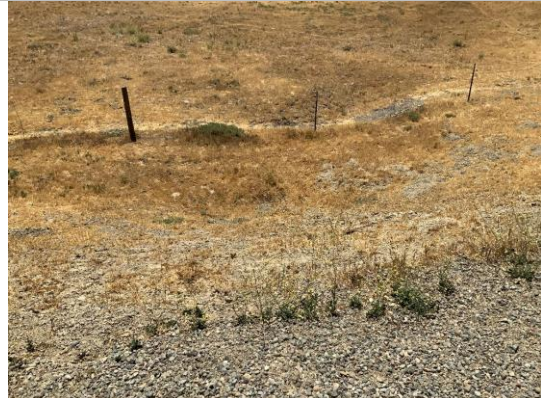
Photo 2 of 3 : UCIP_FA_2022_71180_99568.jpg

LS view: Toe from crown.

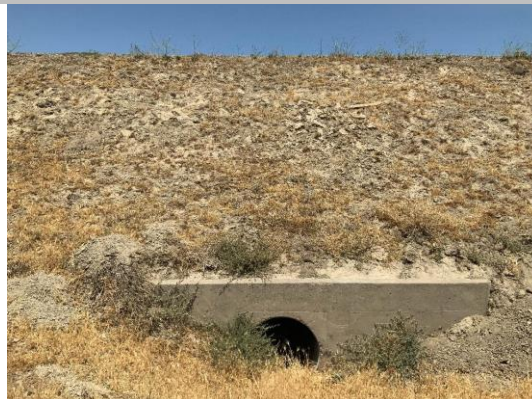
Photo 3 of 3 : UCIP_FA_2022_71180_99569.jpg

LS view: Slope and headwall at toe.

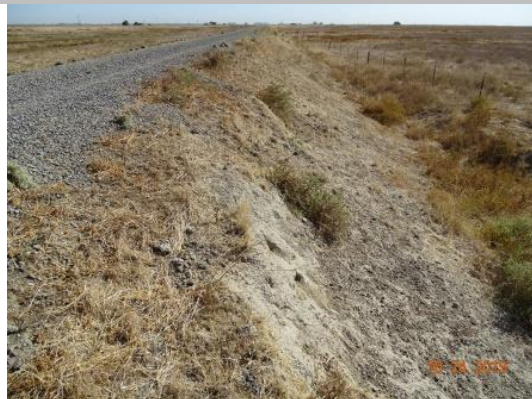
Photo 1 of 1 : FA_2022_NA0010_126_28_20220822_00008.jpg

LM Start	1.21	Rating **	M	Issue No.	28
LM End	1.21	Issue Type +	Ma	Location *	LS
Category	Earthen Levee			GPS Latitude/Longitude	
				Start	End
Item	Erosion / Livestock			37.263179 °	37.263179 °
				-120.755444 °	-120.755444 °
DWR ID	DWR_NA0010_08_f_2019_28				
Comment Code					
E4 : Repair the levee slope damaged by livestock and prevent large animal access.					
Inspector Comment

View of slope damage on the landside of the levee looking upstream.
(Fall 2019)

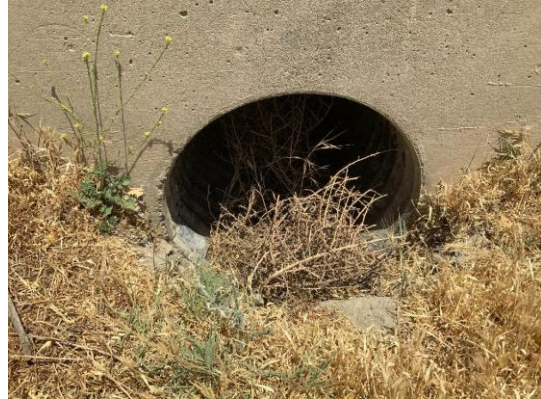
Photo 1 of 1 : UCIP_FA_2022_71181_99576.jpg

Comment Code						
Inspector Comment						
DS_ID:19833 FS_ID:71181 EP_NO: N/A Repair Type: Non-Urgent EVAL Issue: 11, Maintenance Compliance Issue Crossing Status: Found UCIP Comments: 06/2/2021 Record remains Non-Urgent. Some vegetation in LS pipe inlet, recommend clearing out. DWR DMP internal inspection has not found pipe integrity issues. LOF of crossing is less or equal to 4.0. Recommend next video inspection in 5 years. No permit was found authorizing this encroachment. CVFPB will need to review crossing to determine owner. The UCIP inspection was completed with GEI staff, P. Espinoza. (H. Dunn – GEI) 04/16/2014 Debris blocking landward headwall--recommend clearing. (W. Wylie - DWR UCIP) FIELD_STRUCT_DESC: 24-inch corrugated metal gravity drainage pipe (CMP) through the levee, 11.6 feet below the crown. Flap gate on the waterside (WS) end. Concrete headwall on each end. [Additional Reference(s): DWR Levee Log, 2002, (HLM 1.20). USACE San Joaquin O&M Manual, Unit No. 601, Part No. 1, 1967, Amended in 1978, Revised 20 June 1985, (HLM 1.21). DWR As-Built Specification No. 63-25, Sheet No. 11, 9 May 1963, (HLM 1.21)]. FS Date: 6/2/2021

LS view: Close up of pipe inlet at toe, some vegetation inside pipe.

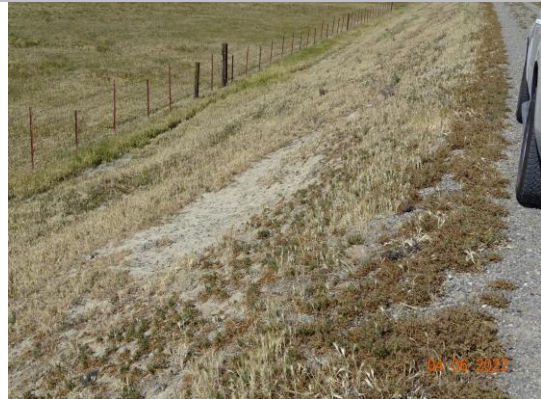
Photo 1 of 1 : FA_2022_NA0010_126_26_20220822_00007.jpg

LM Start	1.81	Rating **	M	Issue No.	26
LM End	1.81	Issue Type +	Ma	Location *	LS
Category	Earthen Levee			GPS Latitude/Longitude	
				Start	End
Item	Erosion / Livestock			37.260673 °	37.260673 °
				-120.745290 °	-120.745290 °
DWR ID	DWR_NA0010_08_f _ 2019_26				
Comment Code					
E4 : Repair the levee slope damaged by livestock and prevent large animal access.					
Inspector Comment

Looking downstream at erosion spot on the landside slope. (Spring 2022)

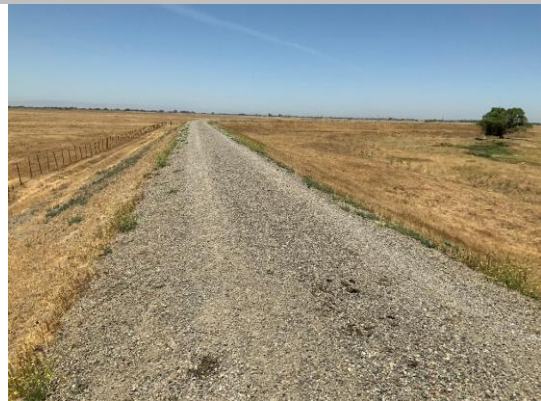
Photo 1 of 3 : UCIP_FA_2022_71183_99586.jpg

Comment Code						
Inspector Comment						
DS_ID:19835 FS_ID:71183 EP_NO: N/A Repair Type: Non-Urgent EVAL Issue: Crossing Status: Found UCIP Comments: 06/2/2021 Record remains Non-Urgent. LS pipe end not visible at all, appears to be buried or removed. Need to contact owner to determine status of pipe. DWR DMP internal inspection has not found pipe integrity issues. LOF of crossing is less or equal to 4.0. Recommend next video inspection in 5 years. No permit was found authorizing this encroachment. CVFPB will need to review crossing to determine owner. The UCIP inspection was completed with GEI staff, P. Espinoza. (H. Dunn – GEI) 04/16/2014 Non-functional landward inlet is buried in sediment. Need to contact owner to determine status. (W. Wylie - DWR UCIP) FIELD_STRUCT_DESC: 24-inch corrugated metal gravity drainage pipe (CMP) through the levee, 12.0 feet below the crown. Flap gate on the waterside (WS) end. Concrete headwall on each end. [Additional Reference(s): DWR Levee Log, 2002, (HLM 2.04). USACE San Joaquin O&M Manual, Unit No. 601, Part No. 1, 1967, Amended in 1978, Revised 20 June 1985, (HLM 2.05). DWR As-Built Specification No. 63-25, Sheet No. 12, 9 May 1963, (HLM 2.05)]. FS Date: 6/2/2021

Levee crown looking downstream.

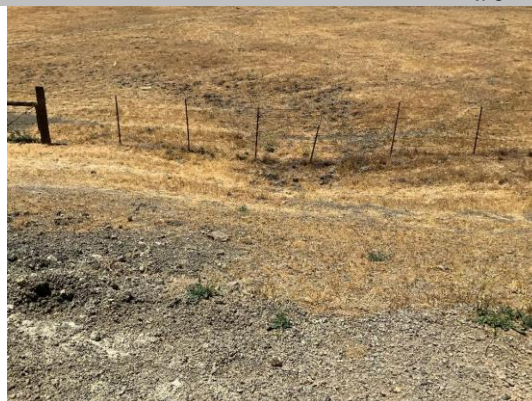
Photo 2 of 3 : UCIP_FA_2022_71183_99587.jpg

LS view: Toe from crown, no pipe visible.

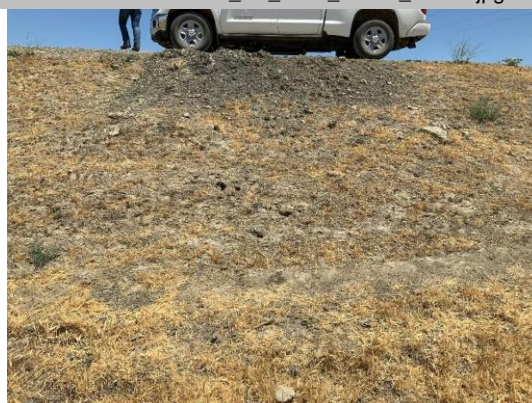
Photo 3 of 3 : UCIP_FA_2022_71183_99588.jpg

LS view: Slope from toe, no pipe visible.

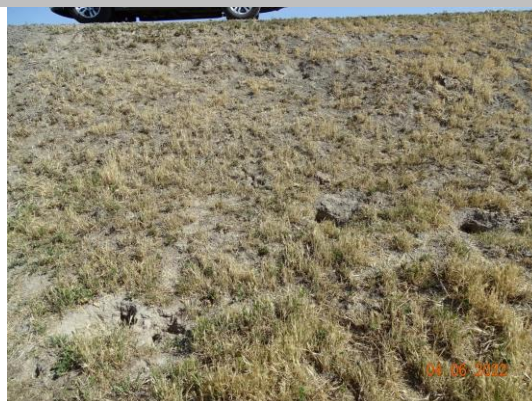
Photo 1 of 1 : FA_2022_NA0010_126_25_20220822_00006.jpg

LM Start	2.07	Rating **	M	Issue No.	25
LM End	2.07	Issue Type +	Ma	Location *	LS
Category	Earthen Levee			GPS Latitude/Longitude	
				Start	End
Item	Animal Control			37.258059 °	37.258059 °
				-120.742451 °	-120.742451 °
DWR ID	DWR_NA0010_08_f_2019_25				
Comment Code					
A1 : Exterminate rodents and backfill and compact or grout burrows.					
Inspector Comment

Looking uphill at rodent holes in the landside slope. (Spring 2022)

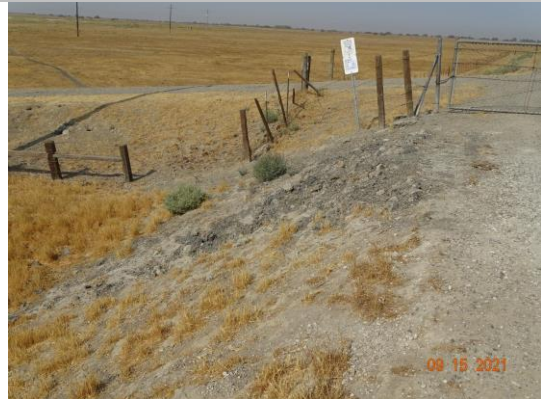
Photo 1 of 1 : FA_2022_NA0010_126_22_20220822_00005.jpg

LM Start	2.07	Rating **	A/W	Issue No.	22
LM End	2.07	Issue Type +	Ma	Location *	LS
Category	Earthen Levee			GPS Latitude/Longitude	
				Start	End
Item	Erosion / Livestock			37.258076 °	37.258076 °
				-120.742439 °	-120.742439 °
DWR ID	DWR_NA0010_08_f _ 2018_22				
Comment Code					
E4 : Repair the levee slope damaged by livestock and prevent large animal access.					
Inspector Comment					
Erosion from livestock has been repaired. Monitor for settlement.

Repaired slope damage should be monitored for settlement. (Fall 2021)

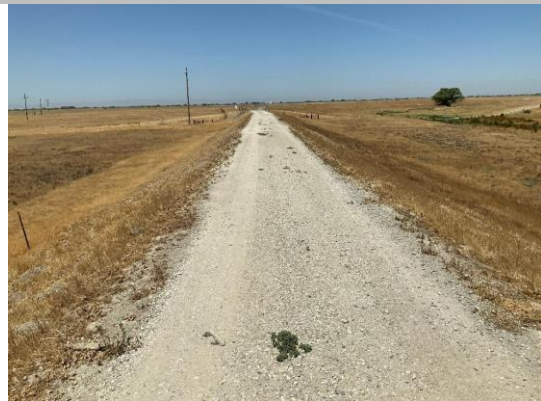
Photo 1 of 3 : UCIP_FA_2022_71184_99597.jpg

Comment Code						
Inspector Comment						
DS_ID:19836 FS_ID:71184 EP_NO: N/A Repair Type: Non-Urgent EVAL Issue: Crossing Status: Found UCIP Comments: 06/2/2021 The record remains Non-Urgent. DWR DMP internal inspection has not found pipe integrity issues. LOF of crossing is less or equal to 4.0. Recommend next video inspection in 5 years. New 6 inch plastic riser with flowmeter and 24 inch metal pipe underground off the LS toe, directly opposite of the LS pipe inlet of this DSID. No permit was found authorizing this encroachment. CVFPB will need to review crossing to determine owner. The UCIP inspection was completed with GEI staff, P. Espinoza. (H. Dunn – GEI) 04/16/2014 Sediment buildup in pipe visible from landward side. (W. Wylie - DWR UCIP) FIELD_STRUCT_DESC: 24-inch corrugated metal gravity drainage pipe (CMP) through the levee, 9.5 feet below the crown. Flap gate on the waterside (WS) end. Concrete headwall on each end. [Additional Reference(s): DWR Levee Log, 2002, (HLM 2.12). USACE San Joaquin O&M Manual, Unit No. 601, Part No. 1, 1967, Amended in 1978, Revised 20 June 1985, (HLM 2.12). DWR As-Built Specification No. 63-25, Sheet No. 12, 9 May 1963, (HLM 2.12)]. FS Date: 6/2/2021

Levee crown looking downstream.

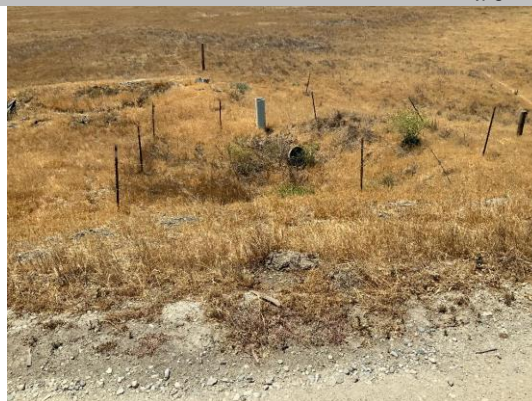
Photo 2 of 3 : UCIP_FA_2022_71184_99599.jpg

LS view: Toe from crown.

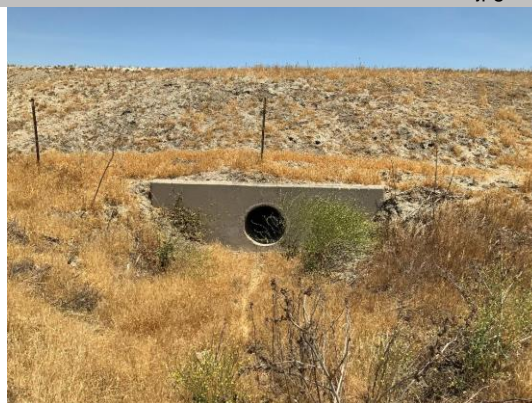
Photo 3 of 3 : UCIP_FA_2022_71184_99600.jpg

LS view: Slope and headwall at toe.

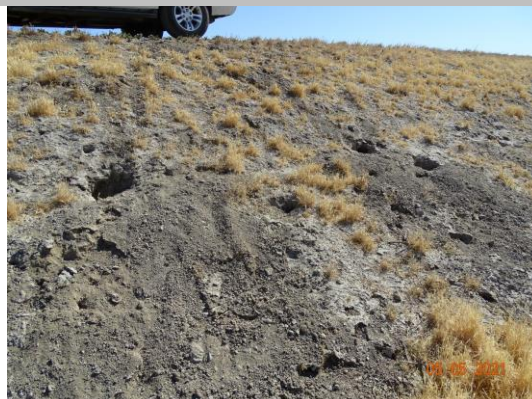
Photo 1 of 1 : FA_2022_NA0010_126_18_20220822_00003.jpg

LM Start	2.29	Rating **	M	Issue No.	18
LM End	2.43	Issue Type +	Ma	Location *	LS
Category	Earthen Levee			GPS Latitude/Longitude	
				Start	End
Item	Animal Control			37.256251 °	37.254767 °
				-120.739280 °	-120.737772 °
DWR ID	DWR_NA0010_08_s_2021_18				
Comment Code					
A1 : Exterminate rodents and backfill and compact or grout burrows.					
Inspector Comment

View of rodent holes in the landside slope. (Spring 2021)

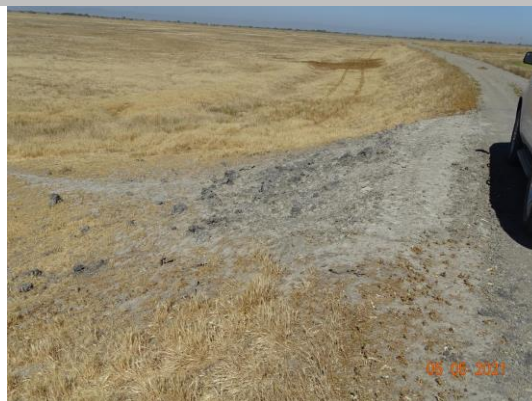
Photo 1 of 1 : FA_2022_NA0010_126_20_20220822_00004.jpg

LM Start	2.74	Rating **	A/W	Issue No.	20
LM End	2.74	Issue Type +	Ma	Location *	LS
Category	Earthen Levee			GPS Latitude/Longitude	
				Start	End
Item	Erosion / Livestock			37.252503 °	37.252503 °
				-120.733282 °	-120.733282 °
DWR ID	DWR_NA0010_08_f _ 2018_20				
Comment Code					
E4 : Repair the levee slope damaged by livestock and prevent large animal access.					
Inspector Comment					
Erosion from livestock has been repaired. Monitor for settlement.

View of repaired slope damage. (Spring 2021)

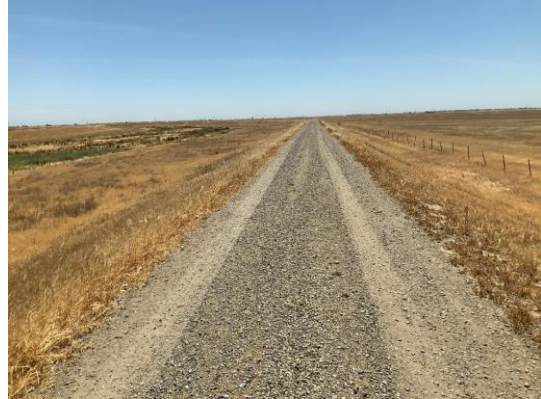
Photo 1 of 3 : UCIP_FA_2022_71185_99604.jpg

Comment Code					
Inspector Comment					
DS_ID:19837 FS_ID:71185 EP_NO: N/A Repair Type: Non-Urgent EVAL Issue: Crossing Status: Found UCIP Comments: 06/2/2021 The record has been upgraded from No Action Needed to Non-Urgent. DWR DMP internal inspection has not found pipe integrity issues. LOF of crossing is less or equal to 4.0. Recommend next video inspection in 5 years. No permit was found authorizing this encroachment. CVFPB will need to review crossing to determine owner. The UCIP inspection was completed with GEI staff, P. Espinoza. (H. Dunn – GEI) FIELD_STRUCT_DESC: 24-inch corrugated metal gravity drainage pipe (CMP) through the levee, 10.5 feet below the crown. Flap gate on the waterside (WS) end. Concrete headwall on each end. [Additional Reference(s): DWR Levee Log, 2002, (HLM 2.77). USACE San Joaquin O&M Manual, Unit No. 601, Part No. 1, 1967, Amended in 1978, Revised 20 June 1985, (HLM 2.77). DWR As-Built Specification No. 63-25, Sheet No. 13, 9 May 1963, (HLM 2.77)]. FS Date: 6/2/2021

Levee crown looking downstream.

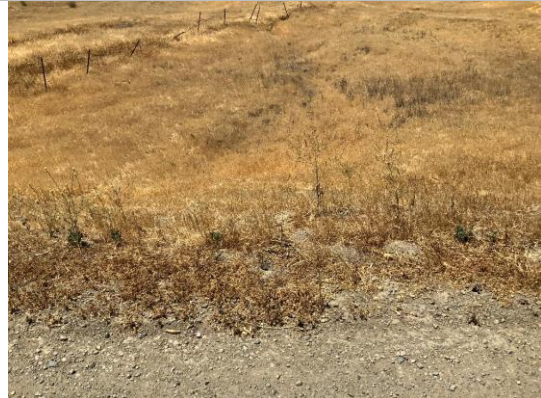
Photo 2 of 3 : UCIP_FA_2022_71185_99605.jpg

LS view: Toe from crown.

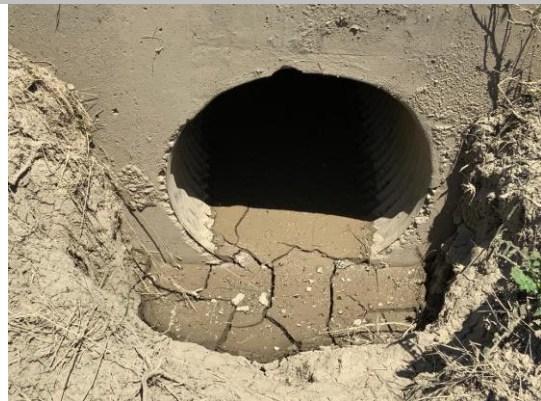
Photo 1 of 1 : UCIP_FA_2022_71186_99610.jpg

DS_ID:19838
 FS_ID:71186
 EP_NO: N/A
 Repair Type: Non-Urgent
 EVAL Issue: 11, Maintenance Compliance Issue
 Crossing Status: Found
 UCIP Comments: 06/2/2021 Record remains Non-Urgent. LS pipe inlet has some sediment buildup, recommend cleaning out. No permit was found authorizing this encroachment. CVFPB will need to review crossing to determine owner. The UCIP inspection was completed with GEI staff, P. Espinoza. (H. Dunn – GEI) 7/20/2016 LS inlet buried under dense vegetation. Dense vegetation limits the inspector's visibility to identify signs of pipe failure (leaks) along the WS and LS slope. Recommend removing vegetation along pipe alignment to conduct proper inspection of structure and appurtenances. (O. Magana - DWR UCIP)4/16/2014 Pipe blocked by silt on LS toe. Flapgate rusty and does not operate correctly. (W. Wylie - DWR UCIP)
 FIELD_STRUCT_DESC: 36-inch corrugated metal gravity drainage pipe (CMP) through the levee, 13.4 feet below the crown. Flap gate on the waterside (WS) end. Concrete headwall on each end. [Additional Reference(s): DWR Levee Log, 2002, (HLM 3.06). USACE San Joaquin O&M Manual, Unit No. 601, Part No. 1, 1967, Amended in 1978, Revised 20 June 1985, (HLM 3.06). DWR As-Built Specification No. 63-25, Sheet No. 13, 9 May 1963, (HLM 3.06)].

LS view: Close up of pipe inlet at toe, some sediment buildup.

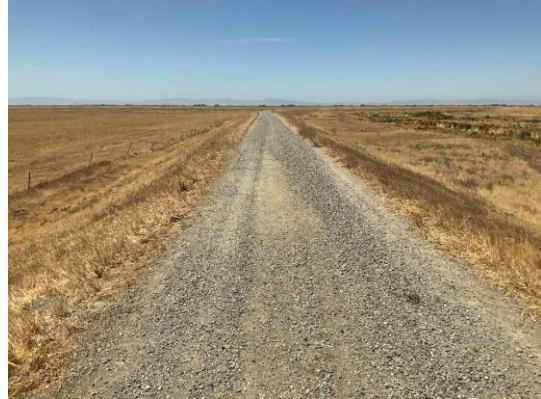
Photo 1 of 3 : UCIP_FA_2022_71187_99618.jpg

Comment Code					
Inspector Comment					
DS_ID:19839 FS_ID:71187 EP_NO: N/A Repair Type: Non-Urgent EVAL Issue: Crossing Status: Found UCIP Comments: 06/2/2021 The record has been upgraded from No Action Needed to Non-Urgent. DWR DMP internal inspection has not found pipe integrity issues. LOF of crossing is less or equal to 4.0. Recommend next video inspection in 5 years. No permit was found authorizing this encroachment. CVFPB will need to review crossing to determine owner. The UCIP inspection was completed with GEI staff, P. Espinoza. (H. Dunn – GEI) FIELD_STRUCT_DESC: 24-inch corrugated metal gravity drainage pipe (CMP) through the levee, 10.0 feet below the crown. Flap gate on the waterside (WS) end. Concrete headwall on each end. [Additional Reference(s): DWR Levee Log, 2002, (HLM 3.23). USACE San Joaquin O&M Manual, Unit No. 601, Part No. 1, 1967, Amended in 1978, Revised 20 June 1985, (HLM 3.24). DWR As-Built Specification No. 63-25, Sheet No. 13, 9 May 1963, (HLM 3.24)]. FS Date: 6/2/2021

Levee crown looking downstream

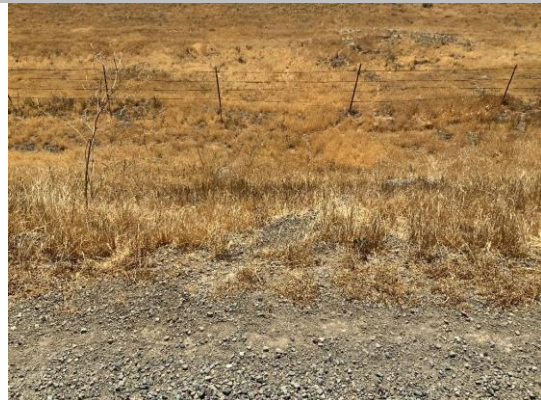
Photo 2 of 3 : UCIP_FA_2022_71187_99619.jpg

LS view: Toe from crown.

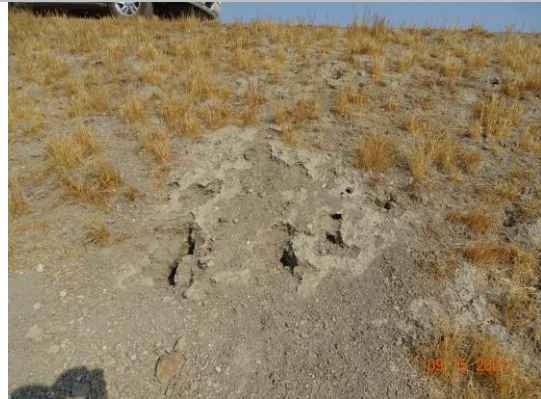
Photo 1 of 1 : FA_2022_NA0010_126_17_20220822_00002.jpg

LM Start	3.28	Rating **	M	Issue No.	17
LM End	3.28	Issue Type +	Ma	Location *	LS
Category	Earthen Levee			GPS Latitude/Longitude	
				Start	End
Item	Animal Control			37.252537 °	37.252537 °
				-120.724795 °	-120.724795 °
DWR ID	DWR_NA0010_08_f _ 2021_17				
Comment Code					
A3 : No rodents visible, but rodent burrows visible; need to backfill and compact or grout burrows.					
Inspector Comment

View of animal burrows in the landside slope. (Fall 2021)

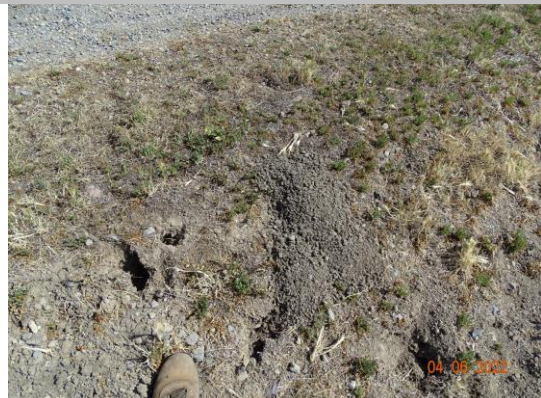
Photo 1 of 1 : FA_2022_NA0010_126_3_20220822_00001.jpg

LM Start	3.40	Rating **	A/W	Issue No.	3
LM End	3.54	Issue Type +	Ma	Location *	LS
Category	Earthen Levee			GPS Latitude/Longitude	
				Start	End
Item	Animal Control			37.253052 °	37.253600 °
				-120.722647 °	-120.720198 °
DWR ID	DWR_NA0010_08_s_2012_3				
Comment Code					
A3 : No rodents visible, but rodent burrows visible; need to backfill and compact or grout burrows.					
Inspector Comment					
Several rodent holes were noted on landside slope within this reach. Continue to monitor in case condition worsens.

Looking at typical view of rodent holes on landward slope. (Spring 2022)

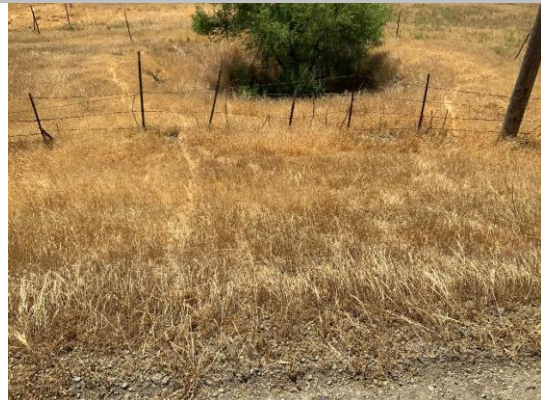
Photo 2 of 3 : UCIP_FA_2022_71188_99625.jpg

LS view: Toe from crown.

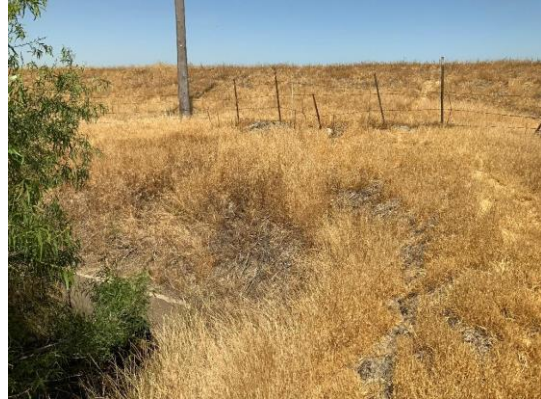
Photo 3 of 3 : UCIP_FA_2022_71188_99626.jpg

LS view: Slope from toe.

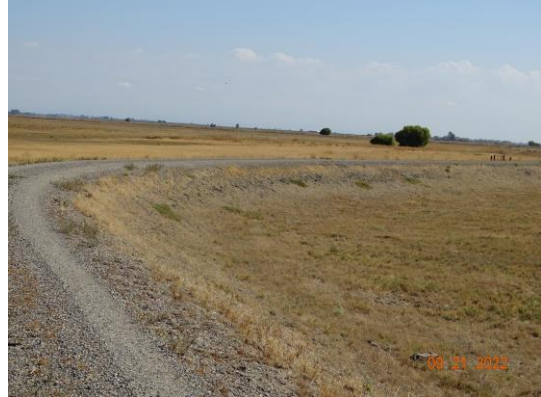
Photo 1 of 1 : FA_2022_NA0010_127_5_20221012_00003.jpg

LM Start	0.22	Rating **	A	Issue No.	5
LM End	0.22	Issue Type +	Ma	Location *	WS
Category	Earthen Levee			GPS Latitude/Longitude	
				Start	End
Item	Vegetation			37.219954 °	37.219954 °
				-120.709638 °	-120.709638 °
DWR ID	DWR_NA0010_09_f _ 2022_5				
Comment Code					
V1 : Control annual grass and weeds on the levee slopes and easements.					
Inspector Comment					
Annual vegetation is well maintained.

View of vegetation management on the waterside slope. (Fall 2022)

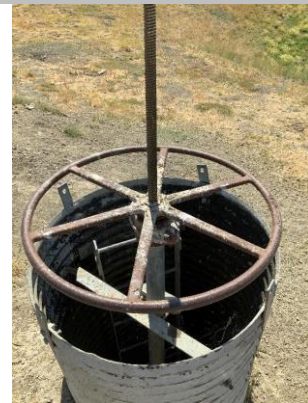
Photo 1 of 1 : UCIP_FA_2022_73203_103172.jpg

Comment Code						
Inspector Comment						
DS_ID:19841 FS_ID:73203 EP_NO: N/A Repair Type: Non-Urgent EVAL Issue: 4b, Safety Issue Crossing Status: Found UCIP Comments: 06/09/2021 The record remains Non-Urgent. Limited inspection of landside (LS) and WS due to water and mud. LS CMP riser has missing lid. WS outlet pipe edges are warped. No permit was found authorizing this encroachment. CVFPB will need to review crossing to determine owner. The UCIP inspection was completed with GEI staff, H.Dunn. (P.Espinoza – GEI) 04/22/2014 Concrete headwalls on landward and waterward under water. Need photo to confirm condition of concrete headwalls, pipe, and gate on both toes. (W. Wylie - DWR UCIP) FIELD_STRUCT_DESC: 24-inch corrugated metal gravity drainage pipe (CMP) through the levee, 18.7 feet below the crown. Slide gate in a 36-inch CMP riser unit on the waterside (WS) slope. Concrete U-shaped headwall on each end. [Additional Reference(s): DWR Levee Log, 2002, (HLM 0.48). USACE San Joaquin O&M Manual, Unit No. 601, Part No. 1, 1967, Amended in 1978, Revised 20 June 1985, (HLM 0.47). DWR As-Built Specification No. 63-25, Sheet No. 14, 9 May 1963, (HLM 0.47)]. FS Date: 6/9/2021 2:41:00 PM

WS view: Close-up of slide gate in CMP riser on slope.

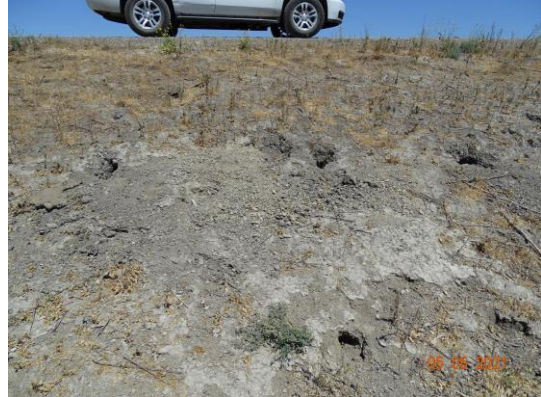
Photo 1 of 1 : FA_2022_NA0010_127_6_20220822_00002.jpg

LM Start	0.48	Rating **	M	Issue No.	6
LM End	0.48	Issue Type +	Ma	Location *	WS
Category	Earthen Levee			GPS Latitude/Longitude	
				Start	End
Item	Animal Control			37.220489 °	37.220489 °
				-120.705021 °	-120.705021 °
DWR ID	DWR_NA0010_09_s_2021_6				
Comment Code					
A1 : Exterminate rodents and backfill and compact or grout burrows.					
Inspector Comment

View of rodent burrows in the waterside slope. (Spring 2021)

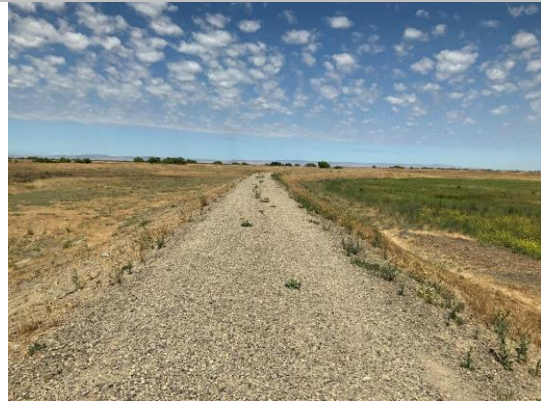
Photo 1 of 3 : UCIP_FA_2022_73202_103232.jpg

Comment Code						
Inspector Comment						
DS_ID:19842 FS_ID:73202 EP_NO: N/A Repair Type: Non-Urgent EVAL Issue: Crossing Status: Found UCIP Comments: 06/09/2021 The record remains Non-Urgent. DWR DMP internal inspection has not found pipe integrity issues. LOF of crossing is less or equal to 4.0. Recommend next video inspection in 5 years. No permit was found authorizing this encroachment. CVFPB will need to review crossing to determine owner. The UCIP inspection was completed with GEI staff, H.Dunn. (P.Espinoza – GEI) 04/22/2014 Animal burrows in area on LS slope. Minor sediment buildup in pipe visible on landward side--recommend clearing. (W. Wylie - DWR UCIP) FIELD_STRUCT_DESC: 24-inch corrugated metal gravity drainage pipe (CMP) through the levee, 8.7 feet below the crown. Flap gate on the waterside (WS) end. Concrete headwall on the landside (LS) end. Concrete U-shaped headwall on the WS end. [Additional Reference(s): DWR Levee Log, 2002, (HLM 0.70). USACE San Joaquin O&M Manual, Unit No. 601, Part No. 1, 1967, Amended in 1978, Revised 20 June 1985, (HLM 0.70). DWR As-Built Specification No. 63-25, Sheet No. 14, 9 May 1963, (HLM 0.70)]. FS Date: 6/9/2021

View of levee crown.

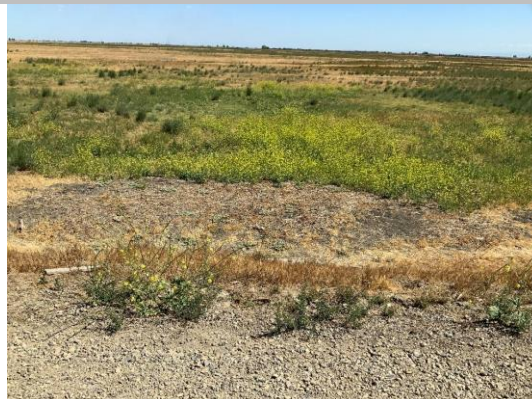
Photo 2 of 3 : UCIP_FA_2022_73202_103233.jpg

LS view: Slope from crown.

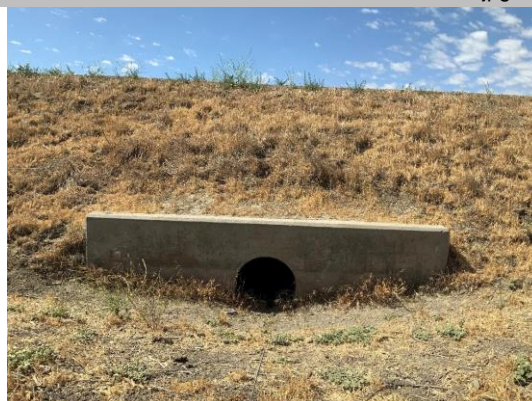
Photo 3 of 3 : UCIP_FA_2022_73202_103235.jpg

LS view: Concrete headwall and inlet pipe at toe.

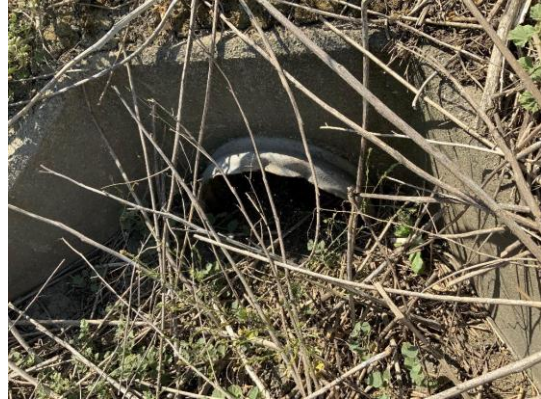
Photo 1 of 2 : UCIP_FA_2022_73200_103189.jpg

DS_ID:19843
FS_ID:73200
EP_NO: N/A
Repair Type: Non-Urgent
EVAL Issue: 4b, Safety Issue
Crossing Status: Found
UCIP Comments: 06/09/2021 The record has been upgraded from No Action Needed to Non-Urgent. No cover or handle on CMP riser on WS slope. Water in riser shows evidence that flapgate is open. Outlet pipe on WS toe not found. Dense vegetation and sediment limits inspectors ability to identify signs of inlet pipe condition on LS toe recommend removal of vegetation and sediment. LS inlet pipe appears to have slight warping around edges. No permit was found authorizing this encroachment. CVFPB will need to review crossing to determine owner. The UCIP inspection was completed with GEI staff, H.Dunn.
(P.Espinoza – GEI)
FIELD_STRUCT_DESC: [Crane Irrigation Structure] 24-inch corrugated metal gravity drainage pipe (CMP) through the levee, 9.7 feet below the crown. Two slide gates in a 48-inch CMP riser unit on the waterside (WS) slope. Concrete U-shaped headwall on the landside (LS) end. WS end cobble revetted on the bank and in the outlet drain. [Additional Reference(s): DWR Levee Log, 2002, (HLM 0.87). USACE San Joaquin O&M Manual, Unit No. 601, Part No. 1, 1967, Amended in 1978, Revised 20 June 1985, (HLM 0.87). DWR As-Built Specification No. 63-25, Sheet No. 14, 9 May 1963, (HLM 0.87)].

LS view: concrete headwall and inlet at LS toe.

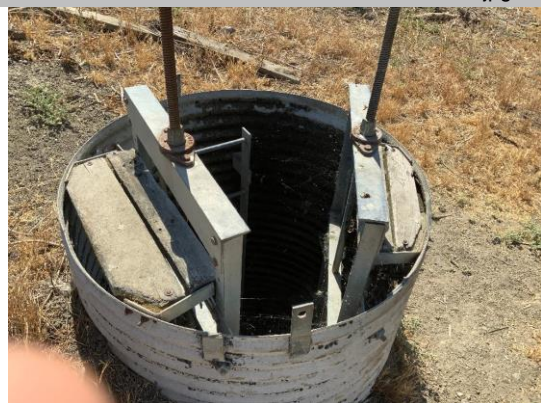
Photo 2 of 2 : UCIP_FA_2022_73200_103184.jpg

WS view: CMP riser with slide gate on slope.

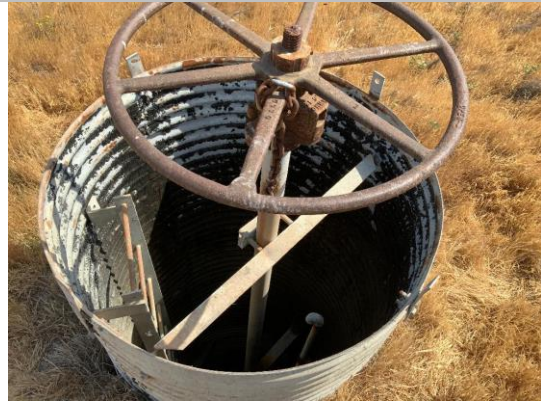
Photo 1 of 1 : UCIP_FA_2022_73210_103402.jpg

Comment Code					
Inspector Comment					
DS_ID:19845 FS_ID:73210 EP_NO: N/A Repair Type: Non-Urgent EVAL Issue: 4b, Safety Issue Crossing Status: Found UCIP Comments: 06/09/2021 The record remains Non-Urgent. No cover on CMP riser on WS slope, creating a safety hazard. Limited inspection of inlet pipe on LS and outlet pipe on WS due to elevated water levels around the headwalls and inlet/outlets, limiting the ability to inspect pipes at a close proximity. No permit was found authorizing this encroachment. CVFPB will need to review crossing to determine owner. The UCIP inspection was completed with GEI staff, H.Dunn. (P.Espinoza – GEI) 04/22/2014 Inlet blocked at LS toe by wooden gate. Need to contact owner to determine status. (W. Wylie - DWR UCIP) FIELD_STRUCT_DESC: 36-inch corrugated metal gravity drainage pipe (CMP) through the levee, 19.6 feet below the crown. Slide gate in a 48-inch CMP riser unit on the waterside (WS) slope. Concrete U-shaped headwall on each end. [Additional Reference(s): DWR Levee Log, 2002, (HLM 0.31). USACE San Joaquin O&M Manual, Unit No. 601, Part No. 1, 1967, Amended in 1978, Revised 20 June 1985, (HLM 0.31). DWR As-Built Specification No. 63-25, Sheet No. 14, 9 May 1963, (HLM 0.31)]. FS Date: 6/9/2021 11:34:00 AM

WS view: Closeup of CMP riser with slidegate on slope.

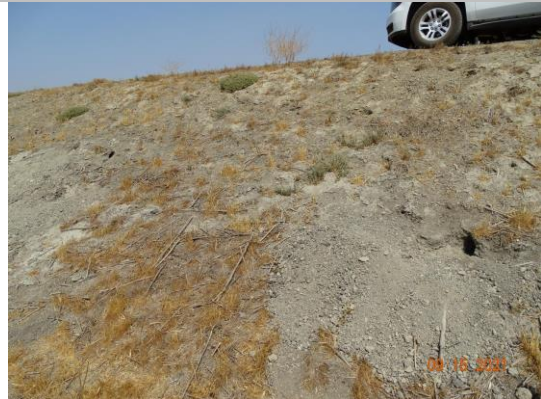
Photo 1 of 1 : FA_2022_NA0010_128_2_20220822_00001.jpg

LM Start	0.51	Rating **	M	Issue No.	2
LM End	0.51	Issue Type +	Ma	Location *	LS
Category	Earthen Levee			GPS Latitude/Longitude	
				Start	End
Item	Animal Control			37.219268 °	37.219268 °
				-120.703046 °	-120.703046 °
DWR ID	DWR_NA0010_10_f_2021_2				
Comment Code					
A3 : No rodents visible, but rodent burrows visible; need to backfill and compact or grout burrows.					
Inspector Comment

View of squirrel holes on the landside slope. (Fall 2021)

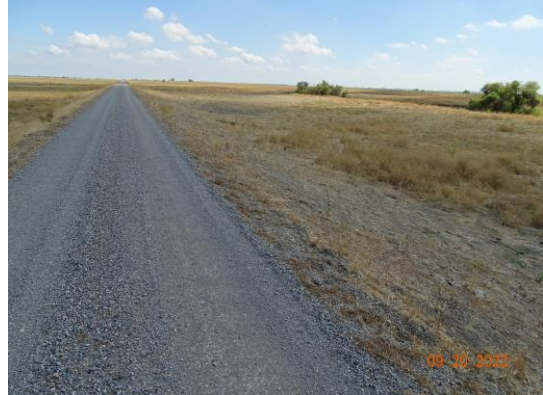
Photo 1 of 1 : FA_2022_NA0010_129_18_20221012_00009.jpg

LM Start	0.01	Rating **	A	Issue No.	18
LM End	0.01	Issue Type +	Ma	Location *	WS
Category	Earthen Levee			GPS Latitude/Longitude	
				Start	End
Item	Vegetation			37.202748 °	37.202748 °
				-120.754985 °	-120.754985 °
DWR ID	DWR_NA0010_11_f _ 2022_18				
Comment Code					
V1 : Control annual grass and weeds on the levee slopes and easements.					
Inspector Comment					
The annual vegetation is well maintained.

Vegetation management on the waterside slope. (Fall 2022)

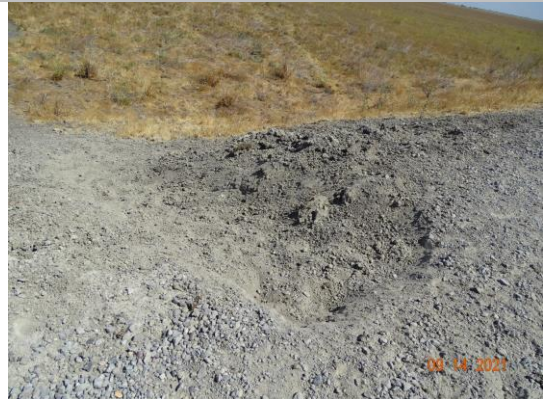
Photo 1 of 1 : FA_2022_NA0010_129_10_20220822_00002.jpg

LM Start	0.16	Rating **	M	Issue No.	10
LM End	0.16	Issue Type +	Ma	Location *	LS
Category	Earthen Levee			GPS Latitude/Longitude	
				Start	End
Item	Erosion / Livestock			37.202730 °	37.202730 °
				-120.752270 °	-120.752270 °
DWR ID	DWR_NA0010_11_f _ 2018_10				
Comment Code					
E4 : Repair the levee slope damaged by livestock and prevent large animal access.					
Inspector Comment					
There is damage to the landside slope and shoulder.

View of livestock damage to the landside slope. (Fall 2021)

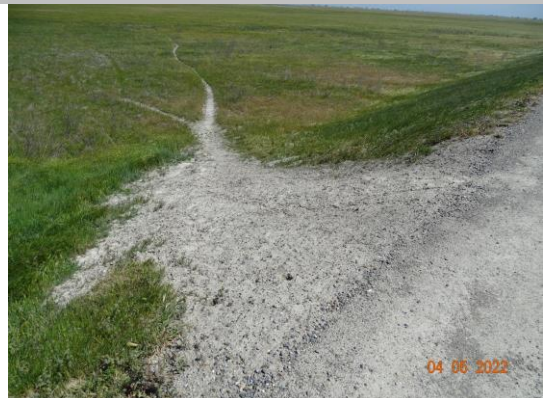
Photo 1 of 1 : FA_2022_NA0010_129_11_20220822_00003.jpg

LM Start	0.21	Rating **	A/W	Issue No.	11
LM End	0.21	Issue Type +	Ma	Location *	LS
Category	Earthen Levee			GPS Latitude/Longitude	
				Start	End
Item	Erosion / Livestock			37.202731 °	37.202731 °
				-120.751389 °	-120.751389 °
DWR ID	DWR_NA0010_11_f _ 2018_11				
Comment Code					
E4 : Repair the levee slope damaged by livestock and prevent large animal access.					
Inspector Comment					
Material has been placed on the levee damage. Monitor for settlement.

View of slope damage on landside. (Spring 2022)

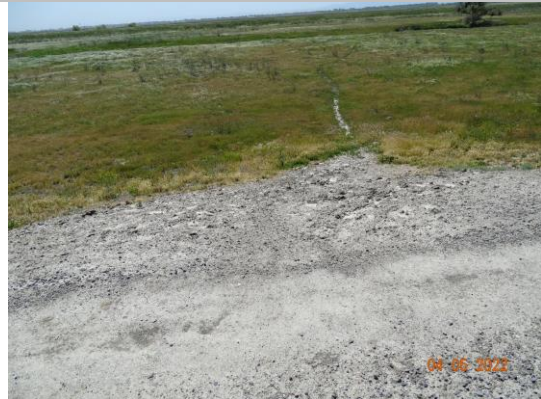
Photo 1 of 1 : FA_2022_NA0010_129_13_20220822_00006.jpg

LM Start	0.21	Rating **	A/W	Issue No.	13
LM End	0.21	Issue Type +	Ma	Location *	WS
Category	Earthen Levee			GPS Latitude/Longitude	
				Start	End
Item	Erosion / Livestock			37.202731 °	37.202731 °
				-120.751389 °	-120.751389 °
DWR ID	DWR_NA0010_11_s_2020_13				
Comment Code					
E4 : Repair the levee slope damaged by livestock and prevent large animal access.					
Inspector Comment					
Material has been placed on the levee damage. Monitor for settlement.

View of damage on waterside shoulder and slope. (Spring 2022)

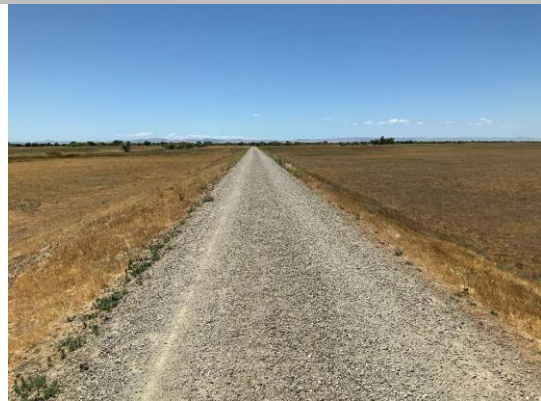
Photo 1 of 3 : UCIP_FA_2022_73267_100411.jpg

Comment Code						
Inspector Comment						
DS_ID:19846 FS_ID:73267 EP_NO: N/A Repair Type: Non-Urgent EVAL Issue: Crossing Status: Found UCIP Comments: 06/8/2021 The record remains Non-Urgent. WS pipe end either completely buried under dirt or has been removed. Only riser visible on WS slope, pipe end not visible at all. Recommend contacting owner to determine status of pipe. No permit was found authorizing this encroachment. CVFPB will need to review crossing to determine owner. The UCIP inspection was completed with GEI staff, P. Espinoza. (H. Dunn- GEI) 04/18/201 Need to contact owner. Recommend clearing sediment deposit inside pipe. (O. Magana - DWR UCIP) FIELD_STRUCT_DESC: 24-inch corrugated metal gravity drainage pipe (CMP) through the levee, 11.0 feet below the crown. Slide gate in a CMP riser unit on the waterside (WS) end. [Additional Reference(s): DWR Levee Log, 2002, (HLM 0.43). USACE San Joaquin O&M Manual, Unit No. 601, Part No. 1, 1967, Amended in 1978, Revised 20 June 1985, (HLM 0.42). DWR As-Built Specification No. 59-01, Sheet No. 61, 10 December 1958, (HLM 0.42)]. FS Date: 6/8/2021

Levee crown looking downstream.

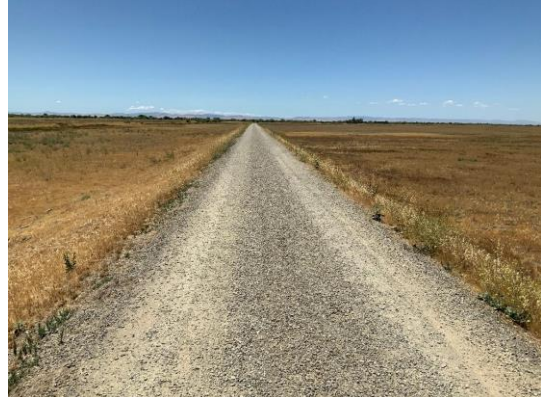
Photo 1 of 3 : UCIP_FA_2022_73268_100419.jpg

DS_ID:19847
FS_ID:73268
EP_NO: N/A
Repair Type: Non-Urgent
EVAL Issue:
Crossing Status: Found
UCIP Comments: 06/8/2021 The record remains Non-Urgent. DWR DMP internal inspection has not found pipe integrity issues. LOF of crossing is less or equal to 4.0. Recommend next video inspection in 5 years. No permit was found authorizing this encroachment. CVFPB will need to review crossing to determine owner. The UCIP inspection was completed with GEI staff, P. Espinoza. (H. Dunn - GEI) 04/18/201
Need to contact owner. Recommend clearing sediment deposit inside pipe. (O. Magana - DWR UCIP)
FIELD_STRUCT_DESC: 24-inch corrugated metal gravity drainage pipe (CMP) through the levee, 10.0 feet below the crown. Flap gate on the waterside (WS) end. [Additional Reference(s): DWR Levee Log, 2002, (HLM 0.65). USACE San Joaquin O&M Manual, Unit No. 601, Part No. 1, 1967, Amended in 1978, Revised 20 June 1985, (HLM 0.65). DWR As-Built Specification No. 59-01, Sheet No. 61, 10 December 1958, (HLM 0.65)].

Levee crown looking downstream.

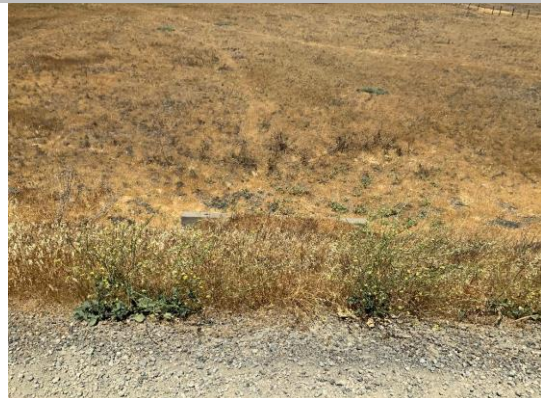
Photo 2 of 3 : UCIP_FA_2022_73268_100416.jpg

LS view: Headwall visible at toe from crown.

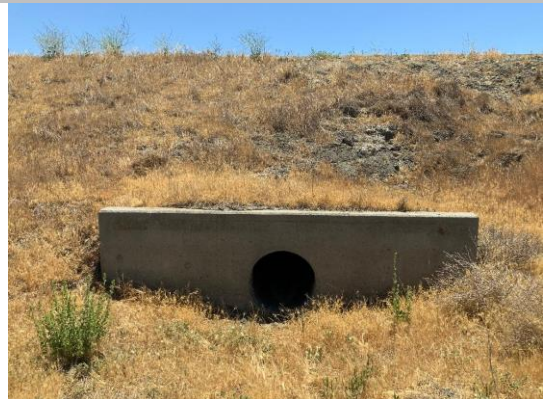
Photo 3 of 3 : UCIP_FA_2022_73269_100423.jpg

LS view: Headwall and slope from toe.

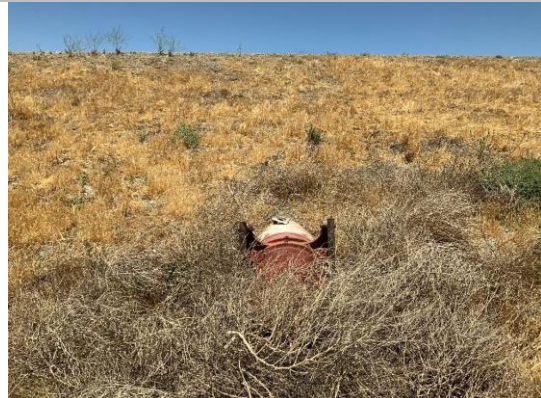
Photo 2 of 2 : UCIP_FA_2022_73270_100433.jpg

WS view: Flapgate and slope from toe. Dense tumbleweeds at toe.

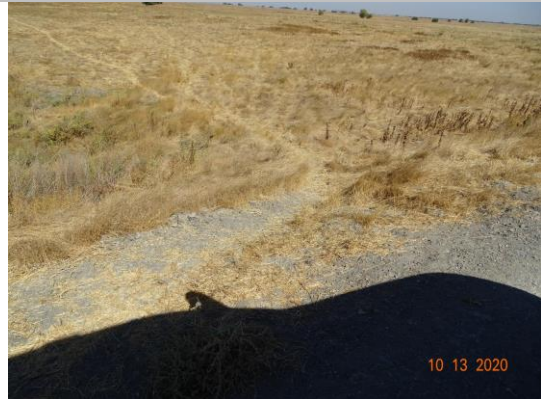
Photo 1 of 1 : FA_2022_NA0010_129_9_20220822_00001.jpg

LM Start	1.49	Rating **	A/W	Issue No.	9
LM End	1.49	Issue Type +	Ma	Location *	LS
Category	Earthen Levee			GPS Latitude/Longitude	
				Start	End
Item	Erosion / Livestock			37.202748 °	37.202748 °
				-120.728182 °	-120.728182 °
DWR ID	DWR_NA0010_11_f_2017_9				
Comment Code					
E4 : Repair the levee slope damaged by livestock and prevent large animal access.					
Inspector Comment

View of livestock trail on the landside slope. (Fall 2020)

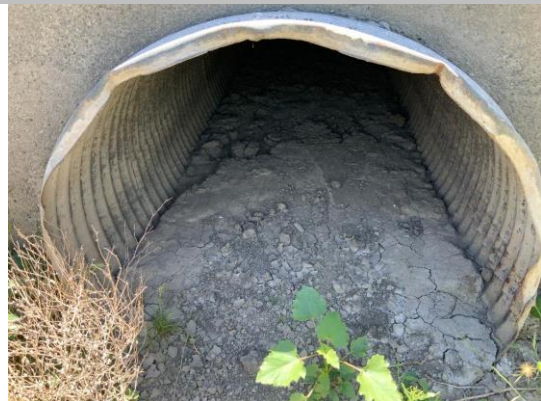
Photo 1 of 1 : UCIP_FA_2022_73277_100440.jpg

Comment Code						
Inspector Comment						
DS_ID:19850 FS_ID:73277 EP_NO: N/A Repair Type: Non-Urgent EVAL Issue: 11, Maintenance Compliance Issue Crossing Status: Found UCIP Comments: 06/8/2021 The record remains Non-Urgent. Sediment buildup in both WS and LS pipe inlet and outlet, recommend clearing out. WS pipe edges are slightly warped. No permit was found authorizing this encroachment. CVFPB will need to review crossing to determine owner. The UCIP inspection was completed with GEI staff, P. Espinoza. (H. Dunn - GEI) 04/18/2014 Need to contact owner. Recommend clearing sediment deposit inside pipe. (O. Magana - DWR UCIP) FIELD_STRUCT_DESC: 48-inch corrugated metal gravity drainage pipe (CMP) through the levee, 16.3 feet below the crown. Slide gate in a pipe riser unit on the waterside (WS) slope. [Additional Reference(s): DWR Levee Log, 2002, (HLM 1.50). USACE San Joaquin O&M Manual, Unit No. 601, Part No. 1, 1967, Amended in 1978, Revised 20 June 1985, (HLM 1.50). DWR As-Built Specification No. 59-01, Sheet No. 62, 10 December 1958, (HLM 1.50)]. FS Date: 6/8/2021

LS view: Close up of pipe inlet with sediment buildup and warped edges at toe.

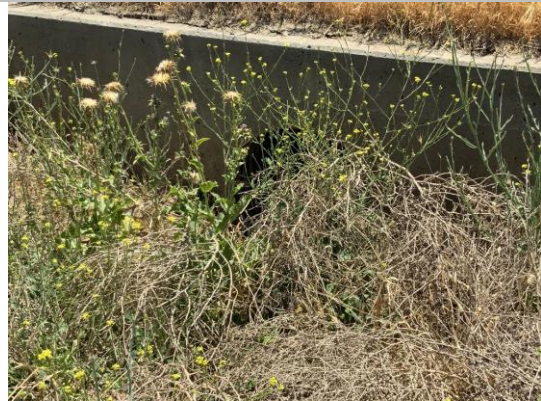
Photo 1 of 2 : UCIP_FA_2022_73272_100446.jpg

Comment Code						
Inspector Comment						
DS_ID:19851 FS_ID:73272 EP_NO: N/A Repair Type: Non-Urgent EVAL Issue: 5, Pipe Damage Crossing Status: Found UCIP Comments: 06/8/2021 The record remains Non-Urgent. DWR DMP internal inspection has found pipe integrity issues. LOF of crossing is between 4.1 and 5. Crossing will be monitored until funding becomes available for rehabilitation. Vegetation on both WS and LS ends, recommend removal. No permit was found authorizing this encroachment. CVFPB will need to review crossing to determine owner. The UCIP inspection was completed with GEI staff, P. Espinoza. (H. Dunn - GEI) 04/18/201 Need to contact owner. Recommend clearing sediment deposit inside pipe. (O. Magana - DWR UCIP) FIELD_STRUCT_DESC: 24-inch corrugated metal gravity drainage pipe (CMP) through the levee, 12.8 feet below the crown. Flap gate on the waterside (WS) end. [Additional Reference(s): DWR Levee Log, 2002, (HLM 1.99). USACE San Joaquin O&M Manual, Unit No. 601, Part No. 1, 1967, Amended in 1978, Revised 20 June 1985, (HLM 1.99). DWR As-Built Specification No. 59-01, Sheet No. 62, 10 December 1958, (HLM 1.99)]. FS Date: 6/8/2021

LS view: Close up of pipe inlet at toe, covered by vegetation.

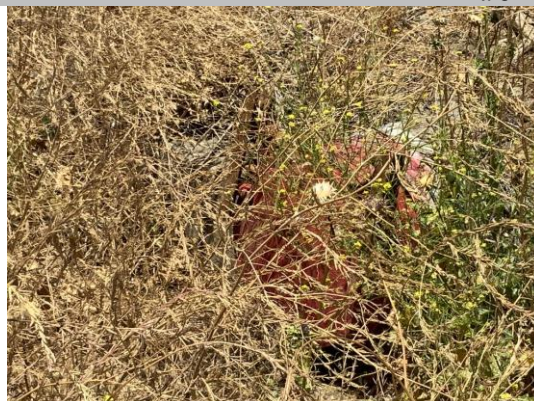
Photo 2 of 2 : UCIP_FA_2022_73272_100450.jpg

WS view: Close up of flapgate at toe, covered by vegetation.

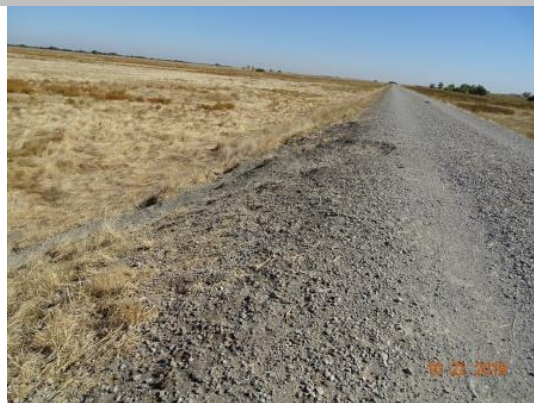
Photo 1 of 1 : FA_2022_NA0010_129_17_20220822_00008.jpg

Damage to the landside slope from livestock traffic. (Fall 2019)

LM Start	2.31	Rating **	M	Issue No.	17
LM End	2.31	Issue Type +	Ma	Location *	LS
Category	Earthen Levee			GPS Latitude/Longitude	
				Start	End
Item	Erosion / Livestock			37.202730 °	37.202730 °
				-120.713368 °	-120.713368 °
DWR ID	DWR_NA0010_11_f_2019_17				
Comment Code					
E4 : Repair the levee slope damaged by livestock and prevent large animal access.					
Inspector Comment

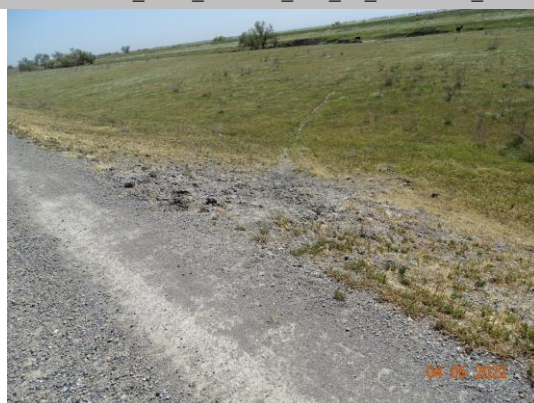
Photo 1 of 2 : FA_2022_NA0010_129_12_20220822_00004.jpg

LM Start	2.46	Rating **	A/W	Issue No.	12
LM End	2.46	Issue Type +	Ma	Location *	LS
Category	Earthen Levee			GPS Latitude/Longitude	
				Start	End
Item	Erosion / Livestock			37.202712 °	37.202712 °
				-120.710633 °	-120.710633 °
DWR ID	DWR_NA0010_11_f_2018_12				
Comment Code					
E4 : Repair the levee slope damaged by livestock and prevent large animal access.					
Inspector Comment					
Damage is from livestock to both landside and waterside slopes but the integrity of the levee is not compromised. Continue to monitor.

View of the landside slope. (Spring 2022)

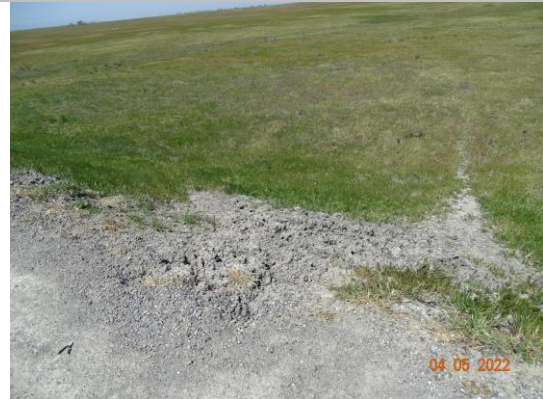
Photo 2 of 2 : FA_2022_NA0010_129_12_20220822_00005.jpg

View of the waterside slope. (Spring 2022)

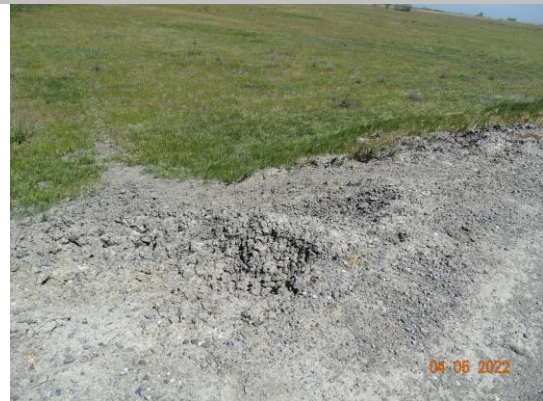
Photo 1 of 1 : FA_2022_NA0010_129_16_20220822_00007.jpg

Looking downhill and damage to the landside slope. (Spring 2022)

LM Start	2.52	Rating **	A/W	Issue No.	16
LM End	2.52	Issue Type +	Ma	Location *	LS
Category	Earthen Levee			GPS Latitude/Longitude	
				Start	End
Item	Erosion / Livestock			37.202738 °	37.202738 °
				-120.709455 °	-120.709455 °
DWR ID	DWR_NA0010_11_s_2022_16				
Comment Code					
E4 : Repair the levee slope damaged by livestock and prevent large animal access.					
Inspector Comment

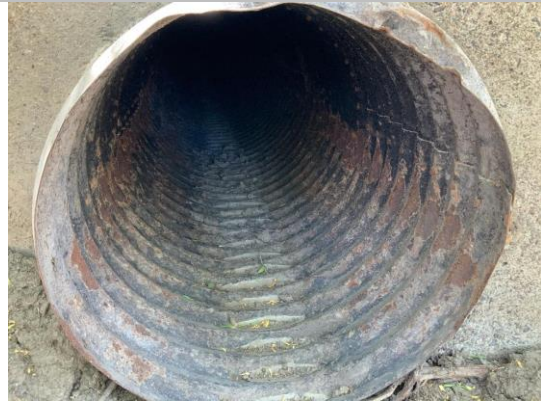
Photo 1 of 2 : UCIP_FA_2022_73273_100451.jpg

Comment Code					
Inspector Comment					
DS_ID:19852 FS_ID:73273 EP_NO: N/A Repair Type: Urgent EVAL Issue: 1, Pipe Integrity Crossing Status: Found UCIP Comments: 06/8/2021 The record has been upgraded from Non-Urgent to Urgent. DWR DMP internal inspection has found pipe integrity issues. LOF of crossing is between 5 and 6. Crossing will be monitored until funding becomes available to address the issues. No permit was found authorizing this encroachment. CVFPB will need to review crossing to determine owner. Pipe has since been cleared out of sediment since previous inspection. The UCIP inspection was completed with GEI staff, P. Espinoza. (H. Dunn- GE)04/18/201 Need to contact owner. Recommend clearing sediment deposit inside pipe. (O. Magana - DWR UCIP) FIELD_STRUCT_DESC: 24-inch corrugated metal gravity drainage pipe (CMP) through the levee, 15.0 feet below the crown. Flap gate on the waterside (WS) end. [Additional Reference(s): DWR Levee Log, 2002, (HLM 3.04). USACE San Joaquin O&M Manual, Unit No. 601, Part No. 1, 1967, Amended in 1978, Revised 20 June 1985, (HLM 3.04). DWR As-Built Specification No. 59-01, Sheet No. 63, 10 December 1958, (HLM 3.04)]. FS Date: 6/8/2021

LS view: Close up of pipe inlet at toe.

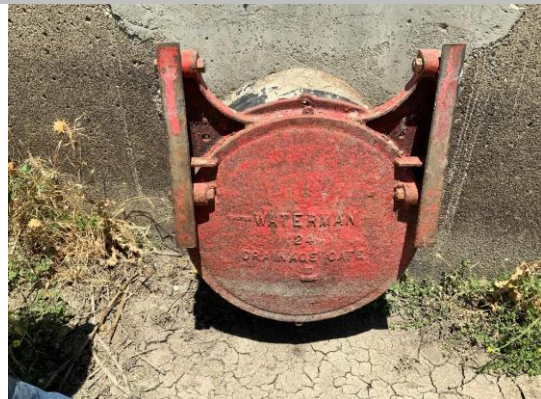
Photo 2 of 2 : UCIP_FA_2022_73273_100455.jpg

WS view: Close up of flapgate at toe.

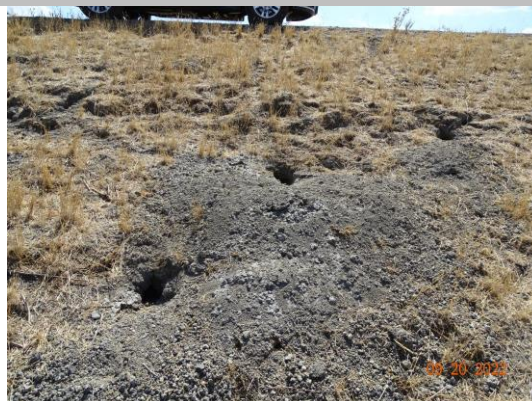
Photo 1 of 1 : FA_2022_NA0010_130_12_20221012_00003.jpg

View of rodent burrows on the waterside slope. (Fall 2022)

LM Start	1.05	Rating **	M	Issue No.	12
LM End	1.05	Issue Type +	Ma	Location *	WS
Category	Earthen Levee			GPS Latitude/Longitude	
				Start	End
Item	Animal Control			37.200910 °	37.200910 °
				-120.736271 °	-120.736271 °
DWR ID	DWR_NA0010_12_f_2022_12				
Comment Code					
A3 : No rodents visible, but rodent burrows visible; need to backfill and compact or grout burrows.					
Inspector Comment

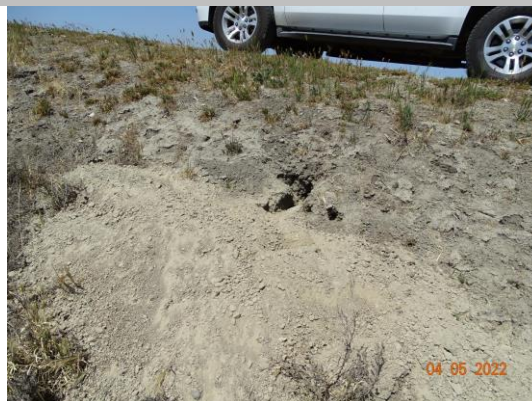
Photo 1 of 1 : FA_2022_NA0010_130_10_20220822_00001.jpg

View of rodent hole with a large quantity of material removed. (Spring 2022)

LM Start	1.15	Rating **	M	Issue No.	10
LM End	1.15	Issue Type +	Ma	Location *	LS
Category	Earthen Levee			GPS Latitude/Longitude	
				Start	End
Item	Animal Control			37.200935 °	37.200935 °
				-120.734471 °	-120.734471 °
DWR ID	DWR_NA0010_12_s_2022_10				
Comment Code					
A3 : No rodents visible, but rodent burrows visible; need to backfill and compact or grout burrows.					
Inspector Comment
