Flood Control Project Maintenance Levee Inspections

Fall 2022 Levee Maintenance Deficiency Summary Report

San Joaquin River Basin

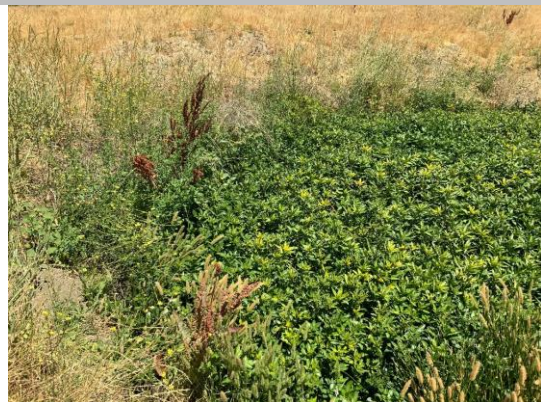
Photo 2 of 2 : UCIP_FA_2022_73306_100641.jpg

WS view: Dense vegetation covering the water at the toe, no pipe visible.

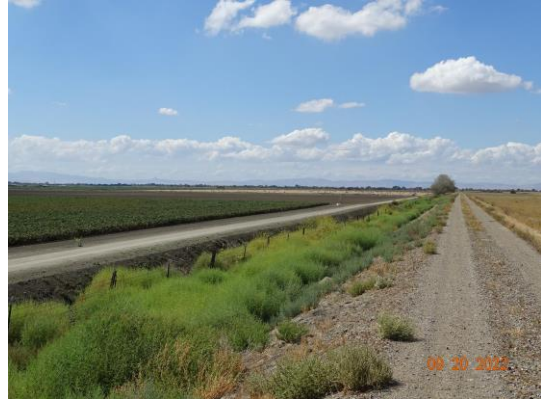
Photo 1 of 1 : FA_2022_NA0010_130_11_20221012_00002.jpg

Looking downstream at vegetation along the landside slope. (Fall 2022)

LM Start	1.43	Rating **	M	Issue No.	11
LM End	1.62	Issue Type +	Ma	Location *	LS
Category	Earthen Levee			GPS Latitude/Longitude	
				Start	End
Item	Vegetation			37.200915 °	37.200913 °
				-120.729332 °	-120.725824 °
DWR ID	DWR_NA0010_12_f_2022_11				
Comment Code					
V1 : Control annual grass and weeds on the levee slopes and easements.					
Inspector Comment

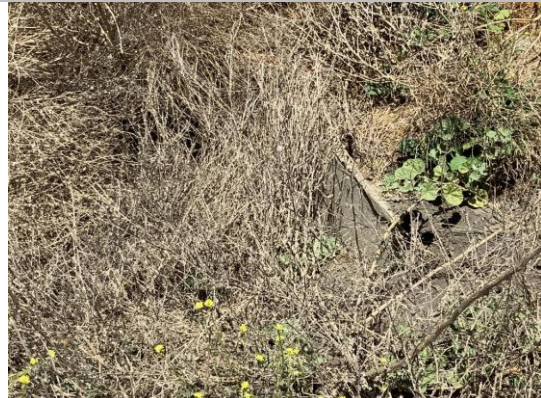
Photo 1 of 1 : UCIP_FA_2022_73307_100645.jpg

Comment Code						
Inspector Comment						
DS_ID:19858 FS_ID:73307 EP_NO: N/A Repair Type: Non-Urgent EVAL Issue: 11, Maintenance Compliance Issue Crossing Status: Found UCIP Comments: 06/8/2021 The record remains Non-Urgent. DWR DMP internal inspection has not found pipe integrity issues. LOF of crossing is less or equal to 4.0. Recommend next video inspection in 5 years. Dense vegetation over LS pipe inlet, headwall barely visible. Recommend removal of vegetation. No permit was found authorizing this encroachment. CVFPB will need to review crossing to determine owner. The UCIP inspection was completed with GEI staff, P. Espinoza. (H. Dunn – GEI) 04/18/2014 Limited access on landward side due to fence and dense vegetation. Recommend obtaining access to landward side and clear vegetation on landward side. (O. Magana - DWR UCIP) FIELD_STRUCT_DESC: 24-inch corrugated metal gravity drainage pipe (CMP) through the levee, 10.7 feet below the crown. Flap gate on the waterside (WS) end. [Additional Reference(s): DWR Levee Log, 2002, (HLM 1.53). USACE San Joaquin O&M Manual, Unit No. 601, Part No. 1, 1967, Amended in 1978, Revised 20 June 1985, (HLM 1.53). DWR As-Built Specification No. 59-01, Sheet No. 62, 10 December 1958, (HLM 1.53)]. FS Date: 6/8/2021

LS view: Headwall barely visible at toe due to dense vegetation.

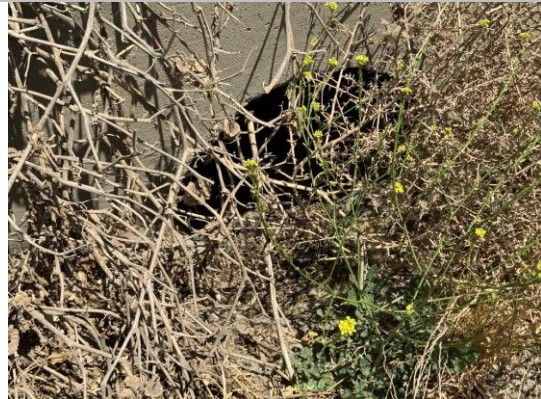
Photo 1 of 1 : UCIP_FA_2022_73309_100661.jpg

LS view: Close up of pipe inlet covered with vegetation.

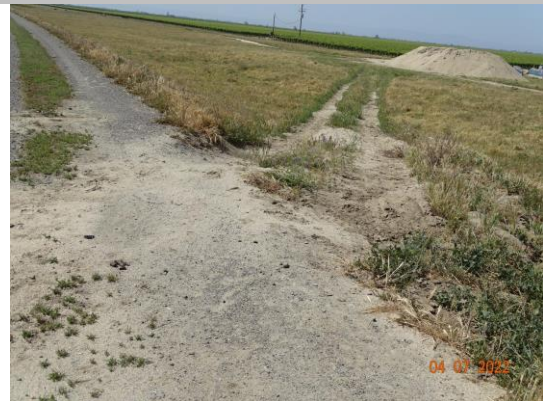
Photo 1 of 1 : FA_2022_NA0010_131_9_20220822_00004.jpg

LM Start	0.48	Rating **	M	Issue No.	9
LM End	0.48	Issue Type +	En	Location *	LS
Category	Earthen Levee			GPS Latitude/Longitude	
				Start	End
Item	Encroachments			37.040343 °	37.040343 °
				-120.439316 °	-120.439316 °
DWR ID	DWR_NA0010_13_f_2021_9				
Comment Code					
RA : Ramp					
Inspector Comment					
Vehicle traffic at unauthorized ramp is beginning to erode the levee shoulder.

Unauthorized ramp constructed on the landside slope. (Spring 2022)

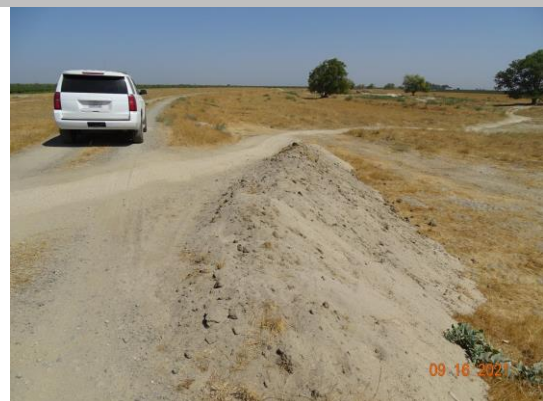
Photo 1 of 1 : FA_2022_NA0010_131_10_20220822_00005.jpg

View of unauthorized ramp on the waterside slope. (Fall 2021)

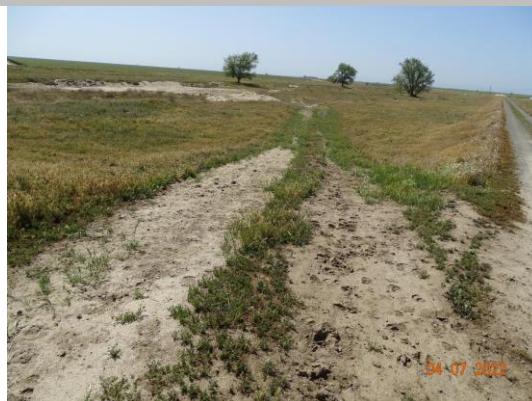
Photo 1 of 1 : FA_2022_NA0010_131_12_20220822_00006.jpg

Unauthorized ramp constructed on the waterside slope. (Spring 2022)

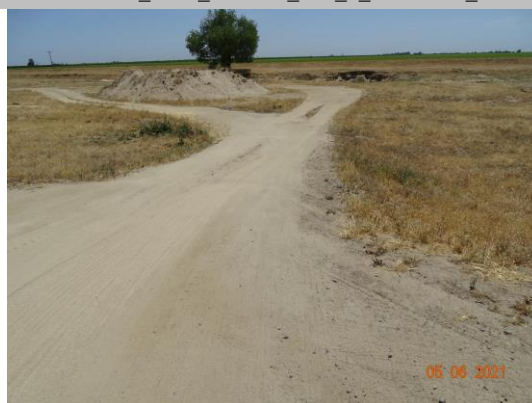
Waterway	Bank	Unit Miles	Inspection Start/End	Inspector
Unit No. 01 San Joaquin River	Right	22.52	09/20/2022 09/20/2022	Corey Fujitani

LM Start	0.91	Rating **	M	Issue No.	5
LM End	0.91	Issue Type +	En	Location *	WS
Category	Earthen Levee			GPS Latitude/Longitude	
				Start	End
Item	Encroachments			37.044855 °	37.044855 °
				-120.434106 °	-120.434106 °
DWR ID	DWR_NA0010_13_s_2014_5				
Comment Code					
RA : Ramp					
Inspector Comment					
There is an unauthorized ramp on waterside slope. Access ramp on the landside is shown in as-built drawings.

Unauthorized ramp constructed on the waterside slope. (Spring 2021)

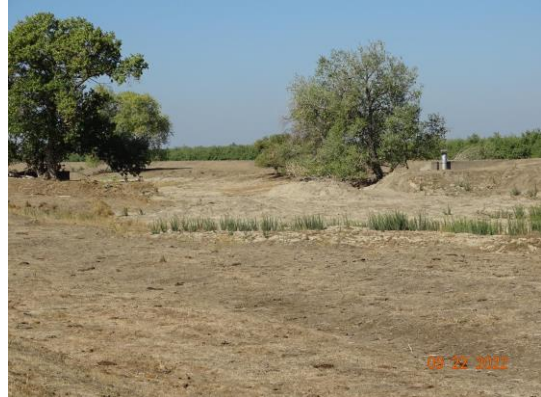
Photo 1 of 2 : FA_2022_NA0010_131_6_20221012_00008.jpg

LM Start	1.14	Rating **	U	Issue No.	6
LM End	1.14	Issue Type +	En	Location *	WS
Category	Earthen Levee			GPS Latitude/Longitude	
				Start	End
Item	Encroachments			37.045541 °	37.045541 °
				-120.430014 °	-120.430014 °
DWR ID	DWR_NA0010_13_f_2015_6				
Comment Code					
WL : Wall					
Inspector Comment					
The sand dam referenced in this issue is an unauthorized construction in the channel by the landowner. Appears to be in progress of being removed.

Upstream view of sand dam being removed. (Fall 2022)

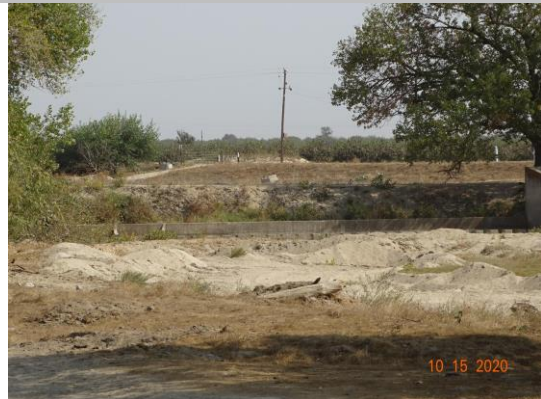
Photo 2 of 2 : FA_2022_NA0010_131_6_20220822_00003.jpg

Downstream view of sand dam constructed upstream of the Ash Slough Drop Structure 4. (Fall 2020)

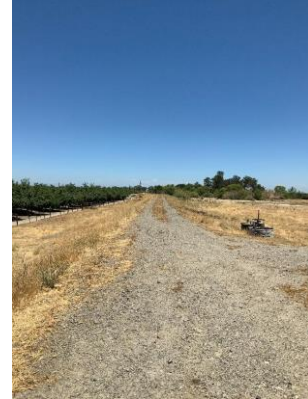
Photo 1 of 3 : UCIP_FA_2022_73336_103411.jpg

Comment Code						
Inspector Comment						
DS_ID:19727 FS_ID:73336 EP_NO: N/A Repair Type: Non-Urgent EVAL Issue: Crossing Status: Found UCIP Comments: 06/23/2021 The record remains Non-Urgent. Appears abandoned due to actuator missing on slidegate on the WS shoulder and if abandoned, should be done properly. Limited inspection of inlet and outlet due to standing water over concrete platforms surrounding pipe inlet/outlet, creating inability to inspect closely. No permit was found authorizing this encroachment. CVFPB will need to review crossing to determine owner. The UCIP inspection was completed with GEI staff, H.Dunn. (P.Espinoza – GEI)03/27/2014 Appears abandoned and if so should be done so properly. Pipe filled with soil on WS at outlet. Actuator missing from slide gate on WS shoulder. (W. Wylie - DWR UCIP) FIELD_STRUCT_DESC: [Rounder Irrigation Structure] 1 of 2: 36-inch corrugated metal gravity drainage pipe (CMP) through the levee, 12.3 feet below the crown. Slide gate in a 48-inch CMP riser unit on the waterside (WS) slope. 6-foot by 12-foot concrete distribution box on the landside (LS). 7-foot by 14-foot concrete outlet structure on the WS toe. [Additional Reference(s): DWR Levee Log, 2002, (HLM 1.14). USACE San Joaquin O&M Manual, Unit No. 601, Part No. 1, 1967, Amended in 1978, Revised 20 June 1985, (HLM 1.14). DWR As-Built Specification No. 64-01, Sheet No. 13, 6 November 1963, (HLM 1.14)]. FS Date: 6/23/2021 1:08:00 PM

View of levee crown.

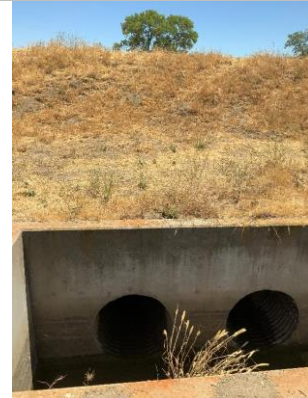
Photo 2 of 3 : UCIP_FA_2022_73336_103418.jpg

LS view: concrete inlet pipe on LS toe.

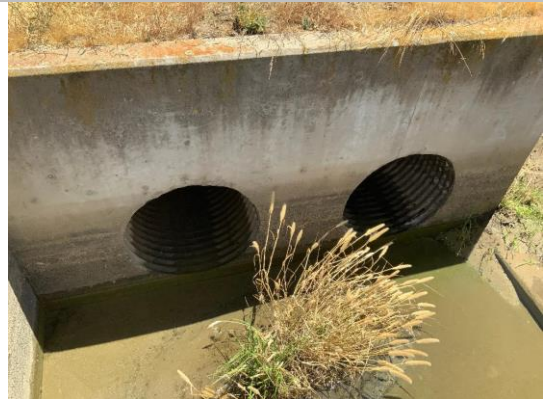
Photo 3 of 3 : UCIP_FA_2022_73336_103419.jpg

LM Start	1.14	Rating **	M	Issue No.	13 (cont)
LM End	1.14	Issue Type +	Ma	Location *	
Category	Supplemental			GPS Latitude/Longitude	
				Start	End
Item	DWR UCIP LMA Responsibility			37.045872 °	37.045872 °
				-120.430070 °	-120.430070 °
DWR ID	19727

LS view: close up of concrete inlet pipe on LS toe.

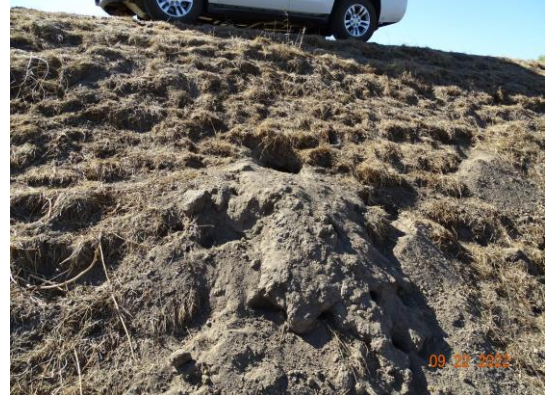
Photo 1 of 1 : FA_2022_NA0010_131_7_20221012_00009.jpg

LM Start	1.21	Rating **	M	Issue No.	7
LM End	1.24	Issue Type +	Ma	Location *	LS
Category	Earthen Levee			GPS Latitude/Longitude	
				Start	End
Item	Animal Control			37.046142 °	37.046229 °
				-120.428848 °	-120.428448 °
DWR ID	DWR_NA0010_13_f_2022_7				
Comment Code					
A3 : No rodents visible, but rodent burrows visible; need to backfill and compact or grout burrows.					
Inspector Comment

Several rodent burrows observed in this section. (Fall 2022)

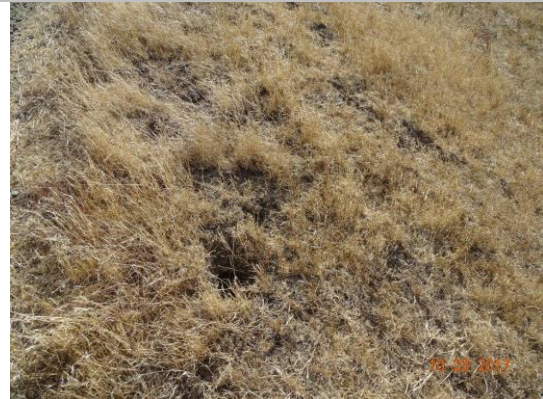
Photo 1 of 1 : FA_2022_NA0010_132_5_20220822_00002.jpg

LM Start	0.25	Rating **	A/W	Issue No.	5
LM End	0.25	Issue Type +	Ma	Location *	LS
Category	Earthen Levee			GPS Latitude/Longitude	
				Start	End
Item	Animal Control			37.035841 °	37.035841 °
				-120.439795 °	-120.439795 °
DWR ID	DWR_NA0010_14_f_2017_5				
Comment Code					
A3 : No rodents visible, but rodent burrows visible; need to backfill and compact or grout burrows.					
Inspector Comment

Looking at the landside slope.

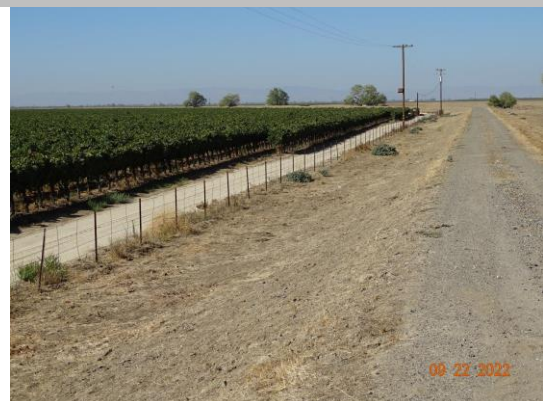
Photo 1 of 1 : FA_2022_NA0010_132_6_20221012_00004.jpg

LM Start	1.12	Rating **	A	Issue No.	6
LM End	1.12	Issue Type +	Ma	Location *	LS
Category	Earthen Levee			GPS Latitude/Longitude	
				Start	End
Item	Vegetation			37.044805 °	37.044805 °
				-120.430150 °	-120.430150 °
DWR ID	DWR_NA0010_14_f_2022_6				
Comment Code					
V1 : Control annual grass and weeds on the levee slopes and easements.					
Inspector Comment					
The annual vegetation is well maintained.

View of the vegetation management on the landside slope. (Fall 2022)

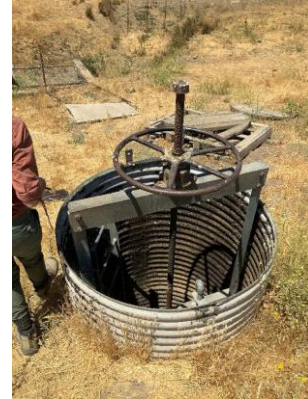
Photo 1 of 1 : UCIP_FA_2022_73338_103435.jpg

Comment Code					
Inspector Comment					
DS_ID:19909 FS_ID:73338 EP_NO: N/A Repair Type: Non-Urgent EVAL Issue: 4b, Safety Issue Crossing Status: Found UCIP Comments: 06/23/2021 The record remains Non-Urgent. DWR DMP internal inspection has found pipe integrity issues. LOF of crossing is between 4.1 and 5. Crossing will be monitored until funding becomes available for rehabilitation. CMP riser on WS slope is missing lid, causing a safety concern. Limited inspection of both inlet and outlet due to elevated standing water in concrete boxes surrounding inlet/outlet, limiting closeup inspection of pipe. No permit was found authorizing this encroachment. CVFPB will need to review crossing to determine owner. The UCIP inspection was completed with GEI staff, H.Dunn. (P.Espinoza – GEI)03/27/2014 Lid should be installed on CMP riser on WS slope, could be a safety hazard. Also dense vegetation limits the inspector's visibility to identify signs of pipe failure (leaks) along the slope. Recommend removing vegetation along pipe alignment to conduct proper inspection of structure. (O. Magana - DWR UCIP) FIELD_STRUCT_DESC: [Rounder Irrigation Structure] 36-inch corrugated metal gravity irrigation pipe (CMP) through the levee, 10.0 feet below the crown. Slide gate in a 48-inch CMP riser unit on the waterside (WS) slope. 6-foot by 7-foot concrete distribution box at the WS toe. Slots for wooden flashboards on the WS of the box. 7-foot by 9-foot concrete distribution box on the landside (LS), 20 feet from the toe. [Additional Reference(s): DWR Levee Log, 2002, (HLM 1.15). USACE San Joaquin O&M Manual, Unit No. 601, Part No. 1, 1967, Amended in 1978, Revised 20 June 1985, (HLM 1.15). DWR As-Built Specification No. 64-01, Sheet No. 13, 6 November 1963, (HLM 1.15)]. FS Date: 6/23/2021

WS view: Slide gate in CMP riser on shoulder.

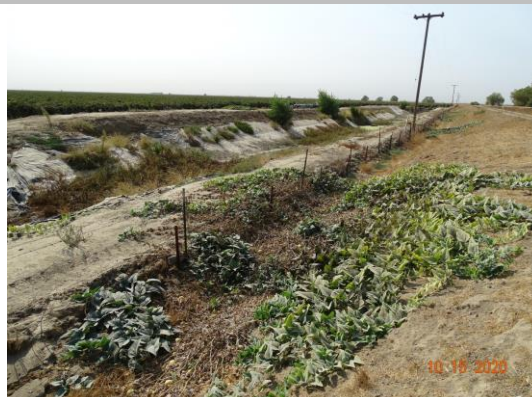
Photo 1 of 1 : FA_2022_NA0010_132_3_20220822_00001.jpg

LM Start	1.15	Rating **	A/W	Issue No.	3
LM End	1.26	Issue Type +	En	Location *	LS
Category	Earthen Levee			GPS Latitude/Longitude	
				Start	End
Item	Encroachments			37.044939 °	37.045416 °
				-120.429636 °	-120.427719 °
DWR ID	DWR_NA0010_14_f_2020_3				
Comment Code					
DT : Ditch					
Inspector Comment					
Retention pond dug approx. 20 feet from landside toe. Monitor.

Retention basin dug approximately 20 ft from the landside toe. (Fall 2020)

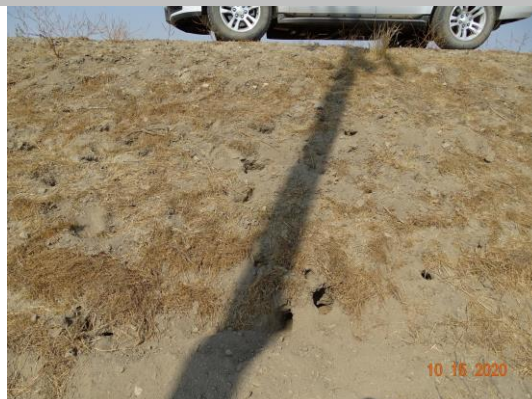
Photo 1 of 1 : FA_2022_NA0010_132_79_20220822_00003.jpg

LM Start	1.24	Rating **	M	Issue No.	79
LM End	1.24	Issue Type +	Ma	Location *	LS
Category	Earthen Levee			GPS Latitude/Longitude	
				Start	End
Item	Animal Control			37.045343 °	37.045343 °
				-120.428007 °	-120.428007 °
DWR ID	DWR_NA0010_14_s_2021_79				
Comment Code					
A3 : No rodents visible, but rodent burrows visible; need to backfill and compact or grout burrows.					
Inspector Comment					
Several rodent holes are noted on the landside at this location.

View of rodent burrows on the landside slope. (Fall 2020)

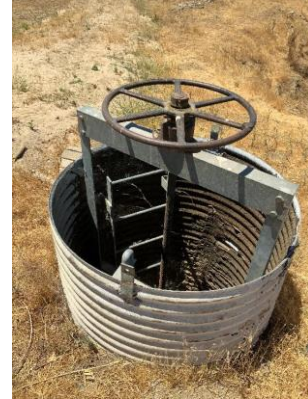
Photo 1 of 1 : UCIP_FA_2022_73339_103812.jpg

Comment Code						
Inspector Comment						
DS_ID:19910 FS_ID:73339 EP_NO: N/A Repair Type: Urgent EVAL Issue: 1, Pipe Integrity Crossing Status: Found UCIP Comments: 06/23/2021 Record has been upgraded from No Action Needed to Urgent. DWR DMP internal inspection has found pipe integrity issues. LOF of crossing is between 5 and 6. Crossing will be monitored until funding becomes available to address the issues. Lid missing from CMP riser on WS slope, causing safety concern. LS not accessible; limited inspection due to barbed wire. No permit was found authorizing this encroachment. CVFPB will need to review crossing to determine owner. The UCIP inspection was completed with GEI staff, H.Dunn. (P.Espinoza – GEI) FIELD_STRUCT_DESC: 36-inch corrugated metal gravity drainage pipe (CMP) through the levee, 9.0 feet below the crown. Slide gate in a 42-inch CMP riser unit on the waterside (WS) slope. Concrete U-shaped headwall on the WS end. Pipe terminates into a concrete ditch on the landside (LS). [Additional Reference(s): DWR Levee Log, 2002, (HLM 1.26). USACE San Joaquin O&M Manual, Unit No. 601, Part No. 1, 1967, Amended in 1978, Revised 20 June 1985, (HLM 1.26). DWR As-Built Specification No. 64-01, Sheet No. 13, 6 November 1963, (HLM 1.26)]. FS Date: 6/23/2021 2:07:00 PM

WS view: close up of CMP riser on slope.

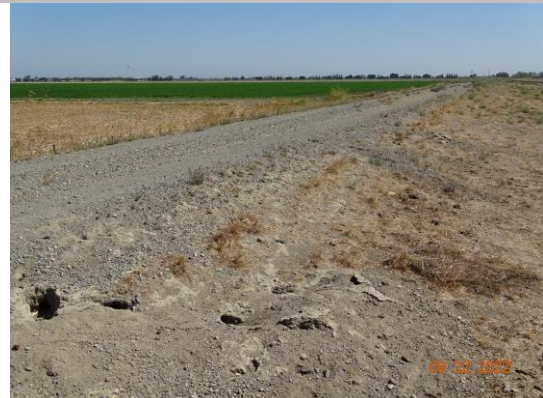
Photo 1 of 1 : FA_2022_NA0010_133_6_20221012_00002.jpg

LM Start	0.95	Rating **	M	Issue No.	6
LM End	0.95	Issue Type +	Ma	Location *	WS
Category	Earthen Levee			GPS Latitude/Longitude	
				Start	End
Item	Animal Control			36.996555 °	36.996555 °
				-120.393195 °	-120.393195 °
DWR ID	DWR_NA0010_15_s_2022_6				
Comment Code					
A1 : Exterminate rodents and backfill and compact or grout burrows.					
Inspector Comment					
Burrows on both landside and waterside slopes.

View of rodent holes in the waterside slope. (Fall 2022)

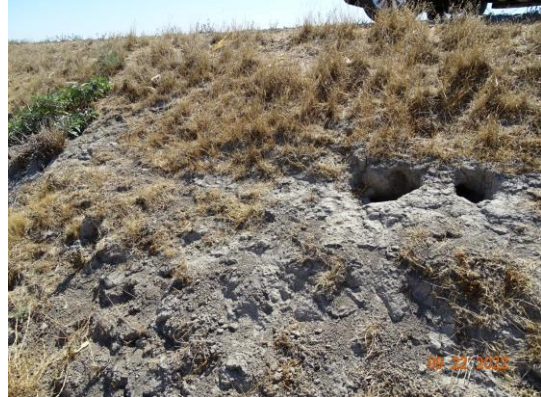
Photo 1 of 1 : FA_2022_NA0010_133_4_20221012_00003.jpg

LM Start	0.96	Rating **	M	Issue No.	4
LM End	0.96	Issue Type +	Ma	Location *	LS
Category	Earthen Levee			GPS Latitude/Longitude	
				Start	End
Item	Animal Control			36.996557 °	36.996557 °
				-120.393095 °	-120.393095 °
DWR ID	DWR_NA0010_15_f_2022_4				
Comment Code					
A3 : No rodents visible, but rodent burrows visible; need to backfill and compact or grout burrows.					
Inspector Comment

View of rodent holes on the landside slope. (Fall 2022)

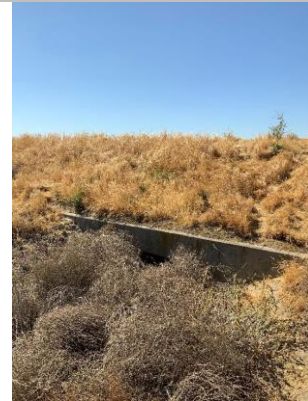
Photo 1 of 1 : UCIP_FA_2022_73366_103825.jpg

Comment Code						
Inspector Comment						
DS_ID:19912 FS_ID:73366 EP_NO: N/A Repair Type: Non-Urgent EVAL Issue: 11, Maintenance Compliance Issue Crossing Status: Found UCIP Comments: 06/24/2021 The record remains Non-Urgent. Limited inspection of LS pipe due to vegetation overgrowth; recommend removal. No permit was found authorizing this encroachment. CVFPB will need to review crossing to determine owner. The UCIP inspection was completed with GEI staff, H.Dunn. (P.Espinoza – GEI) 03/27/2014 Dense vegetation limits the inspector's visibility to identify signs of pipe failure (leaks) along the landward slope. Recommend removing vegetation along pipe alignment to conduct proper inspection of structure. (W. Wylie - DWR UCIP) FIELD_STRUCT_DESC: 30-inch by 30-inch square reinforced concrete box gravity drainage culvert (RCBC) through the levee, 8.5 feet below the crown. Flap gate on the waterside (WS) end. Concrete headwall on the landside (LS) end. Concrete U-shaped headwall on the WS end. [Additional Reference(s): DWR Levee Log, 2002, (HLM 1.01). USACE San Joaquin O&M Manual, Unit No. 601, Part No. 1, 1967, Amended in 1978, Revised 20 June 1985, (HLM 1.01). DWR As-Built Specification No. 64-42, Sheet No. 23, 13 August 1964, (HLM 1.01)]. FS Date: 6/24/2021 3:18:00 PM

LS view: concrete headwall on toe.

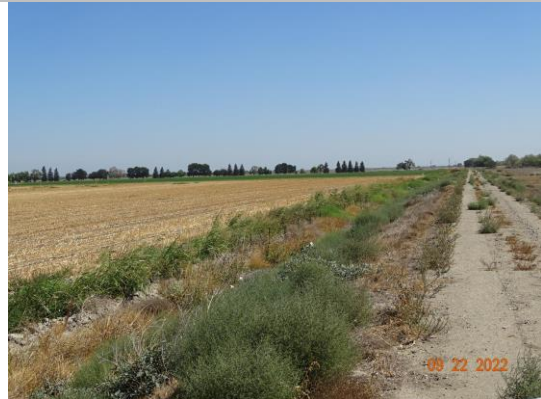
Photo 1 of 1 : FA_2022_NA0010_133_5_20221012_00004.jpg

LM Start	1.51	Rating **	M	Issue No.	5
LM End	1.97	Issue Type +	Ma	Location *	LS
Category	Earthen Levee			GPS Latitude/Longitude	
				Start	End
Item	Vegetation			36.996561 °	36.996586 °
				-120.383110 °	-120.374766 °
DWR ID	DWR_NA0010_15_f_2022_5				
Comment Code					
V1 : Control annual grass and weeds on the levee slopes and easements.					
Inspector Comment

Looking upstream along the landside slope. (Fall 2022)

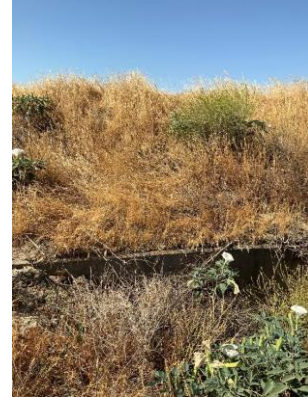
Photo 1 of 2 : UCIP_FA_2022_73367_103831.jpg

Comment Code						
Inspector Comment						
DS_ID:19913 FS_ID:73367 EP_NO: N/A Repair Type: Non-Urgent EVAL Issue: 11, Maintenance Compliance Issue Crossing Status: Found UCIP Comments: 06/24/2021 The record remains Non-Urgent. Limited inspection of LS pipe due to vegetation overgrowth; recommend removal. Note that wooden board is holding flapgate closed on WS; recommend removing before flood season to allow for flow. No permit was found authorizing this encroachment. CVFPB will need to review crossing to determine owner. The UCIP inspection was completed with GEI staff, H.Dunn. (P.Espinoza – GEI) 03/27/2014 Excessive vegetation at inlet on LS toe. (W. Wylie - DWR UCIP) FIELD_STRUCT_DESC: 30-inch by 30-inch square reinforced concrete box gravity drainage culvert (RCBC) through the levee, 8.9 feet below the crown. Flap gate on the waterside (WS) end. Concrete headwall on the landside (LS) end. Concrete U-shaped headwall on the WS end. [Additional Reference(s): DWR Levee Log, 2002, (HLM 1.54). USACE San Joaquin O&M Manual, Unit No. 601, Part No. 1, 1967, Amended in 1978, Revised 20 June 1985, (HLM 1.53). DWR As-Built Specification No. 64-42, Sheet No. 24, 13 August 1964, (HLM 1.53)]. FS Date: 6/24/2021 3:47:00 PM

LS view: concrete headwall from toe.

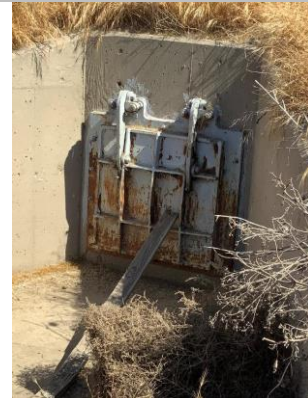
Photo 2 of 2 : UCIP_FA_2022_73367_103833.jpg

WS view: closeup of flapgate.

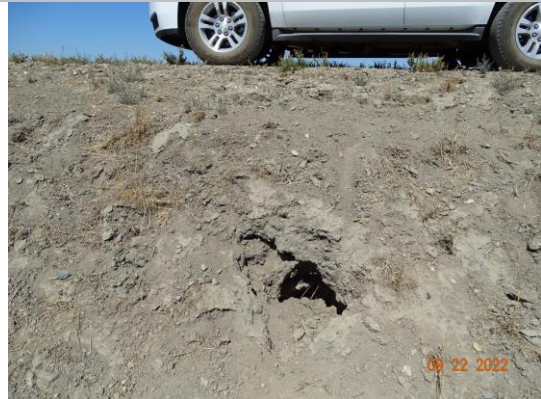
Photo 1 of 1 : FA_2022_NA0010_134_7_20221012_00006.jpg

LM Start	0.22	Rating **	M	Issue No.	7
LM End	0.22	Issue Type +	Ma	Location *	LS
Category	Earthen Levee			GPS Latitude/Longitude	
				Start	End
Item	Animal Control			36.995421 °	36.995421 °
				-120.404956 °	-120.404956 °
DWR ID	DWR_NA0010_16_f_2022_7				
Comment Code					
A3 : No rodents visible, but rodent burrows visible; need to backfill and compact or grout burrows.					
Inspector Comment

Animal burrows on the landside slope. (Fall 2022)

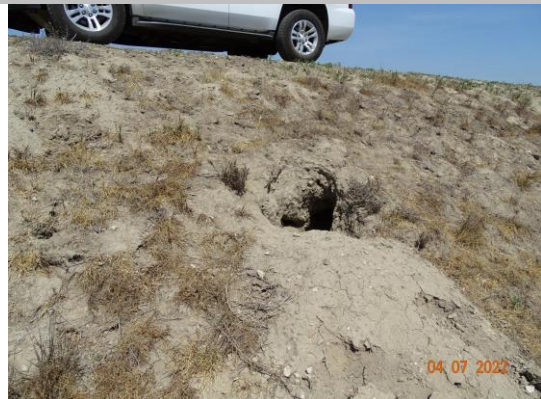
Photo 1 of 1 : FA_2022_NA0010_134_10_20220822_00004.jpg

LM Start	0.30	Rating **	U	Issue No.	10
LM End	0.30	Issue Type +	Ma	Location *	LS
Category	Earthen Levee			GPS Latitude/Longitude	
				Start	End
Item	Animal Control			36.995433 °	36.995433 °
				-120.403543 °	-120.403543 °
DWR ID	DWR_NA0010_16_s_2022_10				
Comment Code					
A3 : No rodents visible, but rodent burrows visible; need to backfill and compact or grout burrows.					
Inspector Comment					
Burrow is approximately 18-inches across.

Large animal burrow on the landside slope. (Spring 2022)

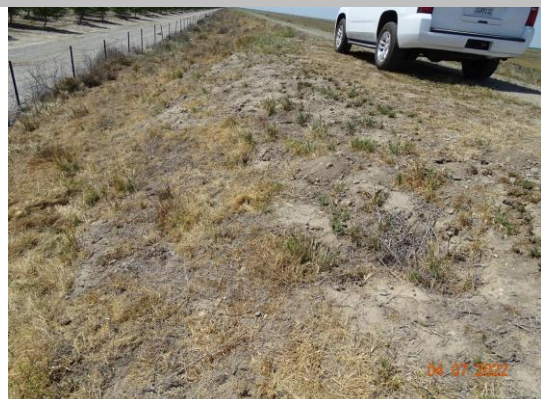
Photo 1 of 1 : FA_2022_NA0010_134_92_20220822_00005.jpg

LM Start	0.93	Rating **	M	Issue No.	92
LM End	0.93	Issue Type +	Ma	Location *	LS
Category	Earthen Levee			GPS Latitude/Longitude	
				Start	End
Item	Animal Control			36.995439 °	36.995439 °
				-120.392146 °	-120.392146 °
DWR ID	DWR_NA0010_16_s_2015_92				
Comment Code					
A3 : No rodents visible, but rodent burrows visible; need to backfill and compact or grout burrows.					
Inspector Comment					
Several rodent holes are identified within this section.

Looking at several rodent holes on landward slope. (Spring 2022)

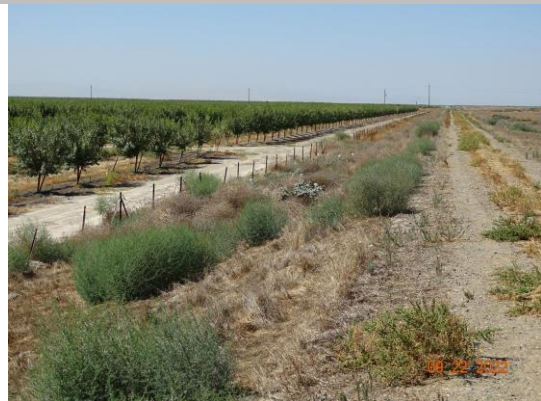
Photo 1 of 1 : FA_2022_NA0010_134_5_20221012_00007.jpg

LM Start	1.41	Rating **	M	Issue No.	5
LM End	1.93	Issue Type +	Ma	Location *	LS
Category	Earthen Levee			GPS Latitude/Longitude	
				Start	End
Item	Vegetation			36.995465 °	36.995490 °
				-120.383505 °	-120.374053 °
DWR ID	DWR_NA0010_16_f _ 2022_5				
Comment Code					
V1 : Control annual grass and weeds on the levee slopes and easements.					
Inspector Comment

Looking downstream along the landside slope. (Fall 2022)

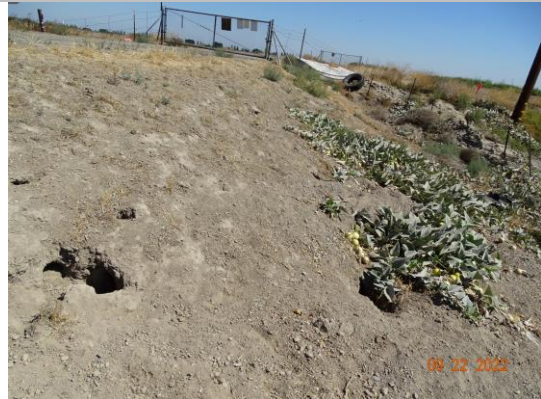
Photo 1 of 2 : UCIP_FA_2022_73370_103851.jpg

LM Start	1.41	Rating **	U	Issue No.	12
LM End	1.41	Issue Type +	Ma	Location *	LS
Category	Earthen Levee			GPS Latitude/Longitude	
				Start	End
Item	Animal Control			36.995467 °	36.995467 °
				-120.383492 °	-120.383492 °
DWR ID	DWR_NA0010_16_s_2022_12				
Comment Code					
A3 : No rodents visible, but rodent burrows visible; need to backfill and compact or grout burrows.					
Inspector Comment

Large rodent holes in the landside slope. (Fall 2022)

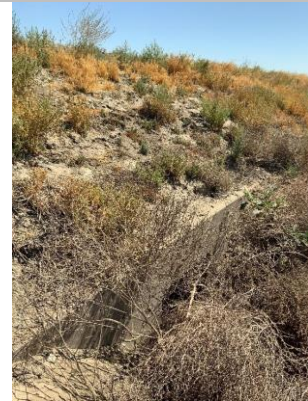
Comment Code						
Inspector Comment						
DS_ID:19915 FS_ID:73370 EP_NO: N/A Repair Type: Non-Urgent EVAL Issue: 11, Maintenance Compliance Issue Crossing Status: Found UCIP Comments: 06/24/2021 The record remains Non-Urgent. Limited inspection on LS and WS due to vegetation overgrowth, recommend removal. No permit was found authorizing this encroachment. CVFPB will need to review crossing to determine owner. The UCIP inspection was completed with GEI staff, H.Dunn. (P.Espinoza – GEI) 04/01/2014 Dense vegetation buildup at landside toe--recommend clearing. (W. Wylie - DWR UCIP) FIELD_STRUCT_DESC: 30-inch by 30-inch square reinforced concrete box gravity drainage culvert (RCBC) through the levee, 8.5 feet below the crown. Two concrete cutoff walls. Flap gate on the waterside (WS) end. Concrete headwall on the landside (LS) end. Concrete U-shaped headwall on the WS end. [Additional Reference(s): DWR Levee Log, 2002, (HLM 1.46). USACE San Joaquin O&M Manual, Unit No. 601, Part No. 1, 1967, Amended in 1978, Revised 20 June 1985, (HLM 1.46). DWR As-Built Specification No. 64-42, Sheet No. 24, 13 August 1964, (HLM 1.46)]. FS Date: 6/24/2021 11:09:00 AM

LS view: Slope and concrete headwall at inlet, covered by heavy vegetation.

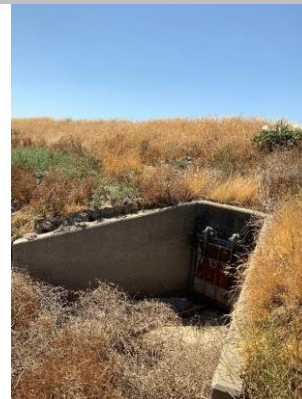
Photo 2 of 2 : UCIP_FA_2022_73370_103849.jpg

WS view: Slope, flapgate, and concrete headwall at toe.

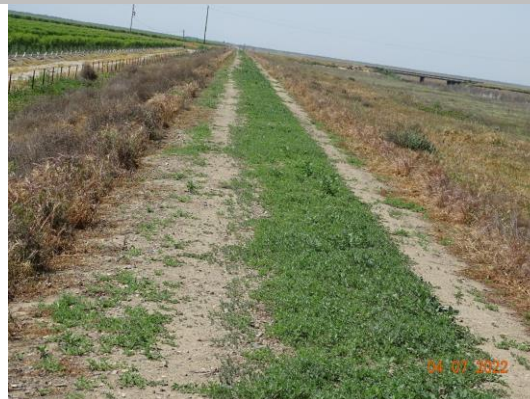
Photo 1 of 1 : FA_2022_NA0010_134_8_20220822_00003.jpg

LM Start	1.65	Rating **	M	Issue No.	8
LM End	1.84	Issue Type +	Ma	Location *	CR
Category	Earthen Levee			GPS Latitude/Longitude	
				Start	End
Item	Vegetation			36.995498 °	36.995502 °
				-120.379192 °	-120.375747 °
DWR ID	DWR_NA0010_16_s_2022_8				
Comment Code					
V3 : Keep the crown roadway free of vegetation.					
Inspector Comment

Looking downstream along the levee crown. (Spring 2022)

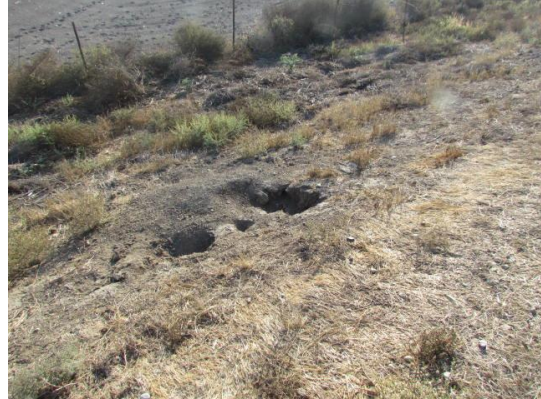
Photo 1 of 1 : FA_2022_NA0010_134_2_20220822_00001.jpg

LM Start	1.77	Rating **	U	Issue No.	2
LM End	1.77	Issue Type +	Ma	Location *	LS
Category	Earthen Levee			GPS Latitude/Longitude	
				Start	End
Item	Animal Control			36.995487 °	36.995487 °
				-120.377054 °	-120.377054 °
DWR ID	DWR_NA0010_16_f _ 2014_2				
Comment Code					
A3 : No rodents visible, but rodent burrows visible; need to backfill and compact or grout burrows.					
Inspector Comment					
Large rodent holes are on the landside slope.

Looking southwest at several rodent holes on landward slope.

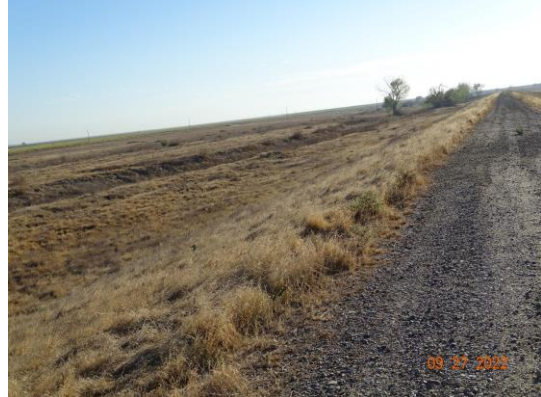
Photo 1 of 1 : FA_2022_NA0010_135_14_20221012_00012.jpg

LM Start	0.00	Rating **	M	Issue No.	14
LM End	2.57	Issue Type +	Ma	Location *	LS
Category	Earthen Levee			GPS Latitude/Longitude	
				Start	End
Item	Vegetation			36.976443 °	36.952324 °
				-120.374741 °	-120.348839 °
DWR ID	DWR_NA0010_17_f _ 2022_14				
Comment Code					
V1 : Control annual grass and weeds on the levee slopes and easements.					
Inspector Comment

View of vegetation on the landside slope. (Fall 2022)

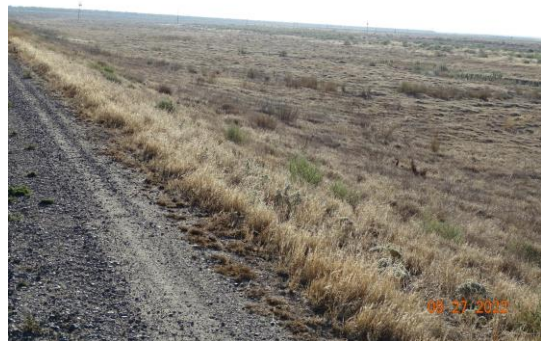
Photo 1 of 1 : FA_2022_NA0010_135_15_20221012_00013.jpg

LM Start	0.02	Rating **	M	Issue No.	15
LM End	2.56	Issue Type +	Ma	Location *	WS
Category	Earthen Levee			GPS Latitude/Longitude	
				Start	End
Item	Vegetation			36.976446 °	36.952464 °
				-120.374382 °	-120.348913 °
DWR ID	DWR_NA0010_17_f _ 2022_15				
Comment Code					
V1 : Control annual grass and weeds on the levee slopes and easements.					
Inspector Comment

Looking southwest along the waterside slope. (Fall 2022)

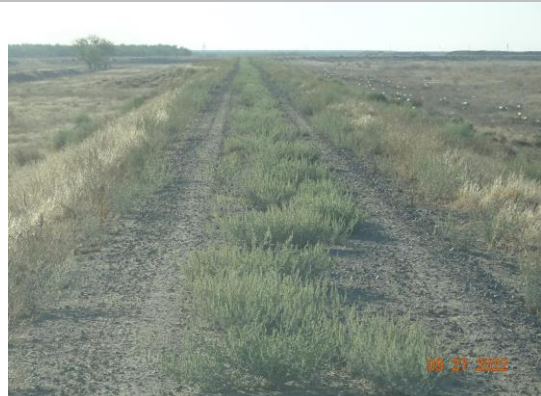
Photo 1 of 1 : FA_2022_NA0010_135_20_20221012_00014.jpg

LM Start	0.72	Rating **	M	Issue No.	20
LM End	1.23	Issue Type +	Ma	Location *	CR
Category	Earthen Levee			GPS Latitude/Longitude	
				Start	End
Item	Vegetation			36.975580 °	36.970273 °
				-120.361968 °	-120.355443 °
DWR ID	DWR_NA0010_17_f_2022_20				
Comment Code					
V3 : Keep the crown roadway free of vegetation.					
Inspector Comment

View of vegetation growing along the levee crown. (Fall 2022)

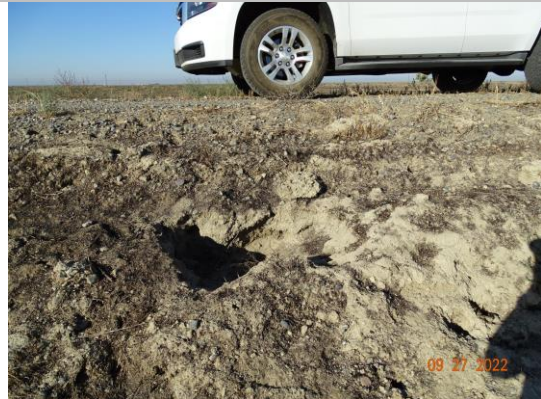
Photo 1 of 1 : FA_2022_NA0010_135_21_20221012_00015.jpg

LM Start	2.88	Rating **	M	Issue No.	21
LM End	2.88	Issue Type +	Ma	Location *	LS
Category	Earthen Levee			GPS Latitude/Longitude	
				Start	End
Item	Animal Control			36.948301 °	36.948301 °
				-120.346357 °	-120.346357 °
DWR ID	DWR_NA0010_17_f_2022_21				
Comment Code					
A3 : No rodents visible, but rodent burrows visible; need to backfill and compact or grout burrows.					
Inspector Comment					
Depression in the landside slope appears to be caused by collapsed rodent burrows. Recommend backfilling and compacting.

Representative animal burrow on the landside slope. (Fall 2022)

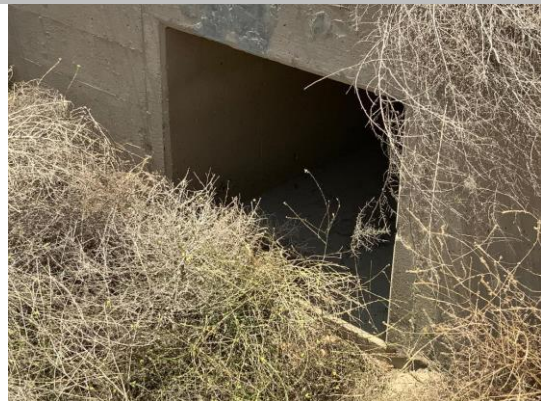
Photo 1 of 2 : UCIP_FA_2022_73436_102410.jpg

Comment Code					
Inspector Comment					
DS_ID:19921 FS_ID:73436 EP_NO: 13587 Repair Type: Non-Urgent EVAL Issue: 11, Maintenance Compliance Issue Crossing Status: Found UCIP Comments: 07/13/2021 The record has been upgraded from No Action Needed to Non-Urgent. Dense vegetation over the WS gate, recommend clearing out for better flow during flood season. Some minor vegetation over LS pipe inlet, recommend removal. The UCIP inspection was completed with GEI staff, P. Espinoza. (H. Dunn – GEI) FIELD_STRUCT_DESC: 48-inch by 60-inch reinforced concrete box gravity drainage culvert (RCBC) through the levee, 14.6 feet below the crown. Concrete U-shaped headwall on the waterside (WS) end. 36-inch weir on the WS. Combination flap gate and slide gate on the WS toe. Steel walkway to slide gate actuator on the WS shoulder. (3.281-foot-high weir and cable-operated flap valve attached to existing 48-inch by 60-inch RCBC authorized under Permit No. 13587, 1983 - Clark Brothers Farming, Arroyo Ranch). [Additional Reference(s): DWR Levee Log, 2002, (HLM 4.68). USACE San Joaquin O&M Manual, Unit No. 601, Part No. 1, 1967, Amended in 1978, Revised 20 June 1985, (HLM 4.69). DWR As-Built Specification No. 64-42, Sheet No. 14, 13 August 1964, (HLM 4.69)]. FS Date: 7/19/2021

LS view: Closeup of pipe inlet at toe.

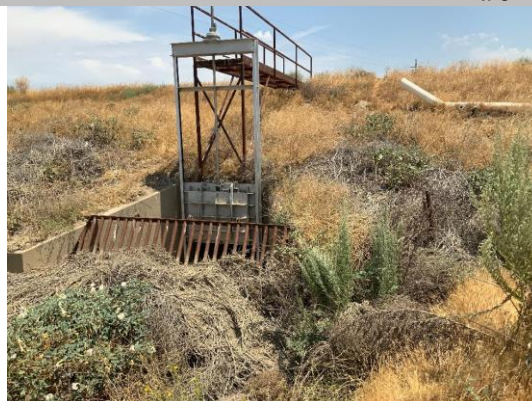
Photo 2 of 2 : UCIP_FA_2022_73436_102413.jpg

WS view: Slidegate and slope from toe.

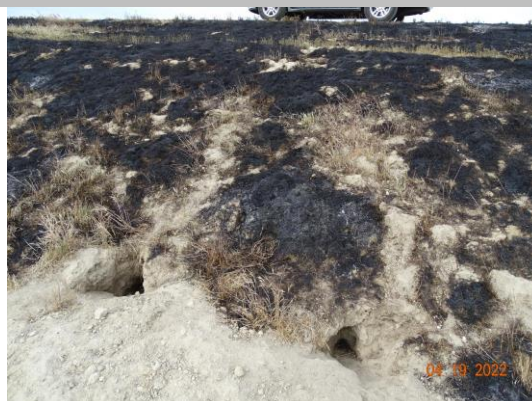
Photo 1 of 1 : FA_2022_NA0010_135_8_20220822_00004.jpg

LM Start	5.75	Rating **	M	Issue No.	8
LM End	5.90	Issue Type +	Ma	Location *	LS
Category	Earthen Levee			GPS Latitude/Longitude	
				Start	End
Item	Animal Control			36.908605 °	36.906507 °
				-120.331112 °	-120.330353 °
DWR ID	DWR_NA0010_17_s_2012_8				
Comment Code					
A1 : Exterminate rodents and backfill and compact or grout burrows.					
Inspector Comment					
Multiple rodent holes are noted on the landside slope and toe.

Looking at several rodent holes on landside slope. (Spring 2022)

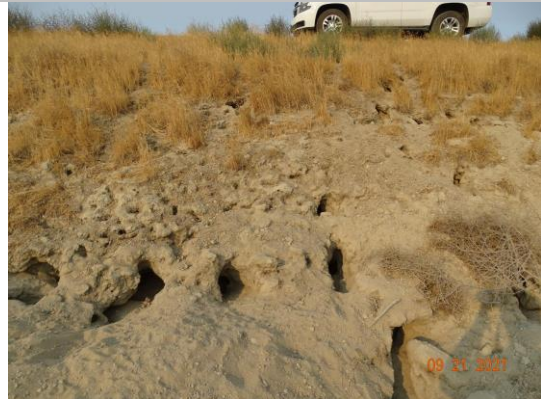
Photo 1 of 1 : FA_2022_NA0010_135_17_20220822_00006.jpg

LM Start	5.92	Rating **	U	Issue No.	17
LM End	5.92	Issue Type +	Ma	Location *	LS
Category	Earthen Levee			GPS Latitude/Longitude	
				Start	End
Item	Animal Control			36.906162 °	36.906162 °
				-120.330258 °	-120.330258 °
DWR ID	DWR_NA0010_17_f_2021_17				
Comment Code					
A3 : No rodents visible, but rodent burrows visible; need to backfill and compact or grout burrows.					
Inspector Comment

View of rodent damage to the landside slope. (Fall 2021)

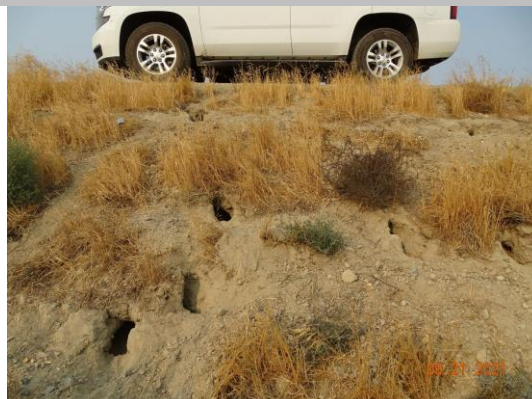
Photo 1 of 1 : UCIP_FA_2022_70656_90667.jpg

LM Start	4.18	Rating **	C	Issue No.	105
LM End	4.18	Issue Type +	Ma	Location *	LS
Category	Earthen Levee			GPS Latitude/Longitude	
				Start	End
Item	Animal Control			37.308458 °	37.308458 °
				-120.923942 °	-120.923942 °
DWR ID	DWR_NA0010_01_f_2017_105				
Comment Code					
A1 : Exterminate rodents and backfill and compact or grout burrows.					
Inspector Comment					
There are several rodent holes noted at this location.

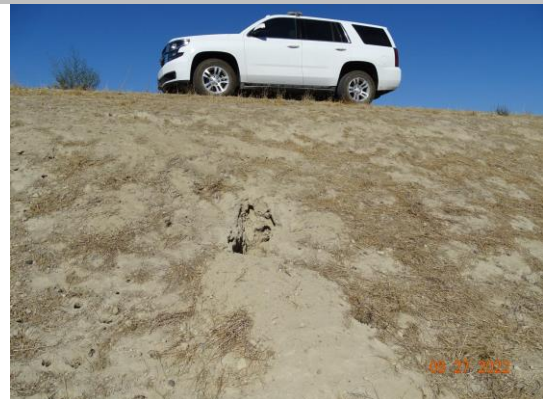
Waterway	Bank	Unit Miles	Inspection Start/End	Inspector
Unit No. 01 San Joaquin River	Right	22.52	09/20/2022 09/20/2022	Corey Fujitani

LM Start	4.69	Rating **	U	Issue No.	1206	
LM End	4.69	Issue Type +	Ma	Location *		
Category	Supplemental			GPS Latitude/Longitude		
				Start		End
Item	DWR UCIP LMA Responsibility			37.302408 °		37.302408 °
				-120.920931 °		-120.920931 °
DWR ID	19609

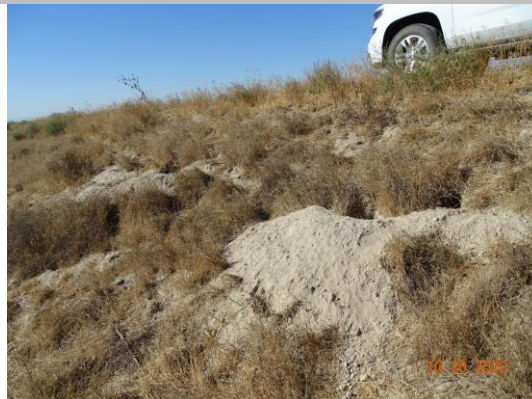
Waterway	Bank	Unit Miles	Inspection Start/End	Inspector
Unit No. 01 San Joaquin River	Right	22.52	09/20/2022 09/20/2022	Corey Fujitani

Lower San Joaquin Levee District

Photo 2 of 3 : UCIP_FA_2022_70658_90678.jpg

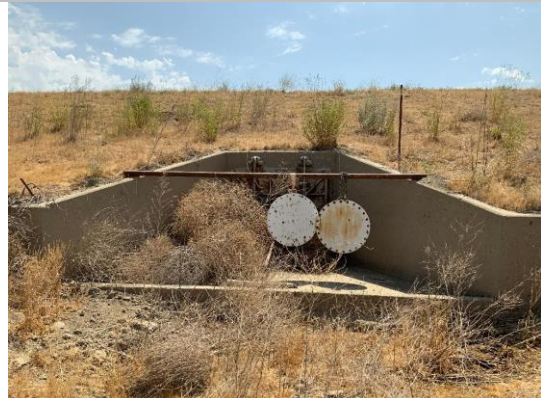
Looking upstream at an irrigation ditch along the landside toe. (Spring 2020)

Levee Inspection Report By Mile - Fall 2022

Comment Code						
Inspector Comment						
DS_ID:19610 FS_ID:70659 EP_NO: N/A Repair Type: Non-Urgent EVAL Issue: Crossing Status: Found UCIP Comments: 10/20/2020 Record remains Non-Urgent. Unable to locate inlet on the LS toe. Ditch runs along the LS toe. Ditch was running full and no signs of pipe inlet were visible. This pipe appears to be non-functional--only WS pipe outlet found. No permit was found authorizing this encroachment. CVFPB will need to review crossing to determine owner. DWR DMP internal inspection is pending and scheduled for 2021. (B. Singh - GEI, O. Magana - DWR UCIP)04/08/2014 Non-functional -- sediment buildup against flapgate and inlet buried at landward side. (W. Wylie - DWR UCIP) FIELD_STRUCT_DESC: 24-inch corrugated metal (CM) gravity drainage pipe through the levee, 8.0 feet below the crown. Flap gate on the waterside (WS) end. Brass cap No. 90 bench mark (BM) on the headwall on the landside (LS). Drainage ditch along the LS toe. [Additional Reference(s): DWR Levee Log, 2002, (HLM 5.06). USACE San Joaquin O&M Manual, Unit No. 601, Part No. 1, (SJR601.1), 1967, Revised 25 May 2011, (HLM 5.05)]. FS Date: 10/20/2020

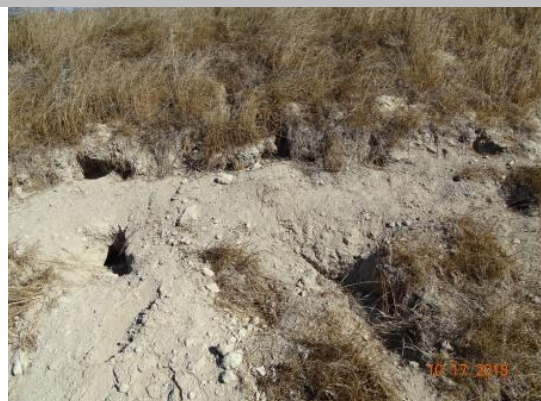
Photo 1 of 3 : UCIP_FA_2022_70660_90689.jpg

Comment Code						
Inspector Comment						
DS_ID:19611 FS_ID:70660 EP_NO: N/A Repair Type: Non-Urgent EVAL Issue: 11, Maintenance Compliance Issue Crossing Status: Found UCIP Comments: 10/20/2020 Record remains Non-Urgent. Depression observed across levee crown, less than 6 inches in depth. Pipe inlet located at the LS toe is completely blocked by soil. This crossing is non-functional. Recommend evaluating the purpose of this drainage structure. No permit was found authorizing this encroachment. CVFPB will need to review crossing to determine owner. DWR DMP internal inspection is pending and scheduled for 2021. Recommend reviewing DMP's internal inspection when completed to investigate reason for depression across the levee crown. (B. Singh - GEI, O. Magana - DWR UCIP)04/08/2014 Dense vegetation limits the inspector's visibility to identify signs of pipe failure (leaks) along waterward and landward slopes. Recommend removing vegetation along pipe alignment to conduct proper inspection of structure and appurtenances. Landward side filled in with soil. Need to contact owner. If crossing is no longer used need to coordinate with CVFPB for proper abandonment. (W. Wylie - DWR UCIP) FIELD_STRUCT_DESC: 24-inch corrugated metal (CM) gravity drainage pipe through the levee, 8.6 feet below the crown. Flap gate on the waterside (WS) end. Brass cap No. 90 bench mark (BM) on the headwall on the landside (LS). [Additional Reference(s): DWR Levee Log, 2002, (HLM 5.96). USACE San Joaquin O&M Manual, Unit No. 601, Part No. 1, (SJR601.1), 1967, Revised 25 May 2011, (HLM 5.95)]. FS Date: 10/20/2020

Overview of levee crown, looking US

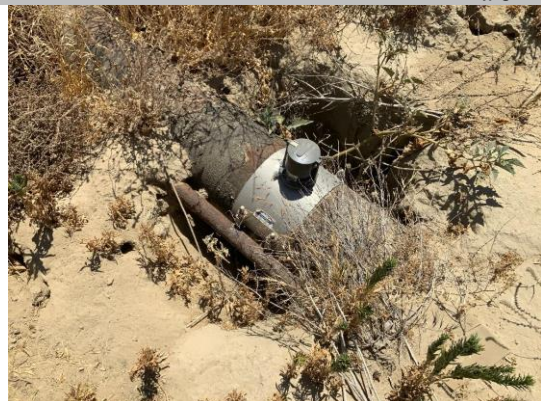
Lower San Joaquin Levee District

Levee Inspection Report By Mile - Fall 2022

LM Start	6.10	Rating **	M	Issue No.	1209 (cont)
LM End	6.10	Issue Type +	Ma	Location *	
Category	Supplemental		GPS Latitude/Longitude		
			Start	End	
Item	DWR UCIP LMA Responsibility		37.304232 °	37.304232 °	
			-120.900706 °	-120.900706 °	
DWR ID	19612

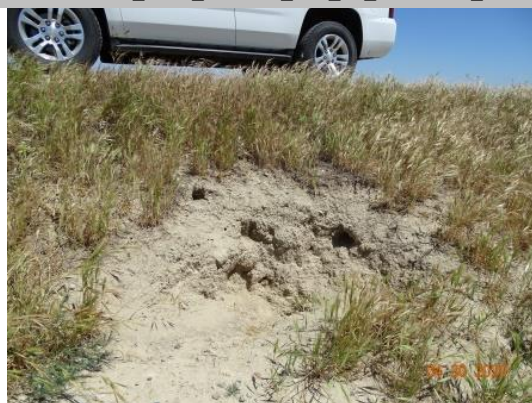
Overview of levee crown, looking US

**Flood Control Project Maintenance
Levee Inspections**

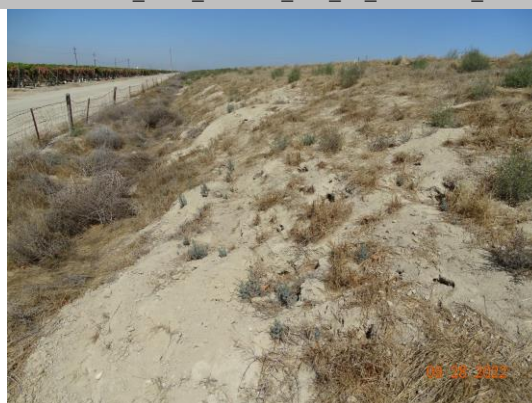
Photo 1 of 1 : FA_2022_NA0010_137_44_20221012_00015.jpg

LM Start	3.93	Rating **	U	Issue No.	44
LM End	3.98	Issue Type +	Ma	Location *	LS
Category	Earthen Levee			GPS Latitude/Longitude	
				Start	End
Item	Animal Control			36.922195 °	36.921549 °
				-120.338412 °	-120.338173 °
DWR ID	DWR_NA0010_18_f_2022_44				
Comment Code					
A3 : No rodents visible, but rodent burrows visible; need to backfill and compact or grout burrows.					
Inspector Comment					
Several rodent burrows observed in the landside slope and berm.

Several rodent holes noted in this section. (Fall 2022)

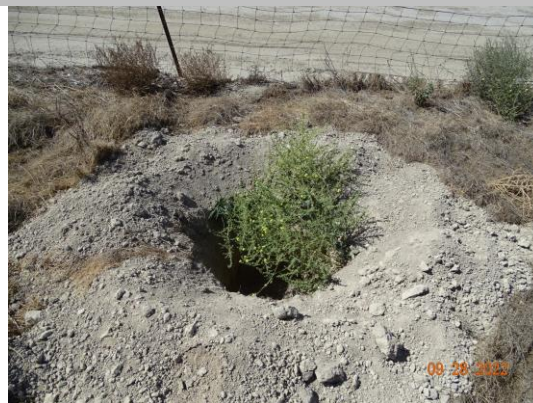
Photo 1 of 1 : FA_2022_NA0010_137_43_20221012_00016.jpg

LM Start	4.58	Rating **	U	Issue No.	43
LM End	4.58	Issue Type +	Ma	Location *	LS
Category	Earthen Levee			GPS Latitude/Longitude	
				Start	End
Item	Animal Control			36.913142 °	36.913142 °
				-120.335093 °	-120.335093 °
DWR ID	DWR_NA0010_18_f_2022_43				
Comment Code					
A3 : No rodents visible, but rodent burrows visible; need to backfill and compact or grout burrows.					
Inspector Comment					
Large hole at the landside toe of the levee.

Large animal hole on the landside toe. (Fall 2022)

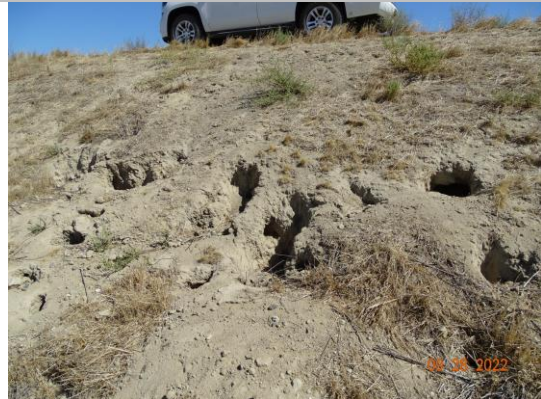
Photo 1 of 1 : FA_2022_NA0010_137_15_20221012_00017.jpg

LM Start	5.74	Rating **	U	Issue No.	15
LM End	5.99	Issue Type +	Ma	Location *	LS
Category	Earthen Levee			GPS Latitude/Longitude	
				Start	End
Item	Animal Control			36.897237 °	36.893924 °
				-120.328633 °	-120.327020 °
DWR ID	DWR_NA0010_18_f_2017_15				
Comment Code					
A3 : No rodents visible, but rodent burrows visible; need to backfill and compact or grout burrows.					
Inspector Comment					
There are multiple large rodent holes at the landside toe.

Several rodent holes noted in the landside slope. (Fall 2022)

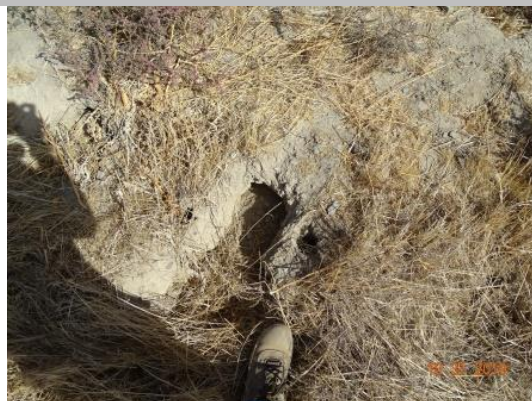
Photo 1 of 1 : FA_2022_NA0010_137_23_20220822_00008.jpg

LM Start	6.84	Rating **	U	Issue No.	23
LM End	6.84	Issue Type +	Ma	Location *	LS
Category	Earthen Levee			GPS Latitude/Longitude	
				Start	End
Item	Animal Control			36.882384 °	36.882384 °
				-120.321417 °	-120.321417 °
DWR ID	DWR_NA0010_18_f_2019_23				
Comment Code					
A1 : Exterminate rodents and backfill and compact or grout burrows.					
Inspector Comment

Representative view of rodent burrows observed at this location. (Fall 2019)

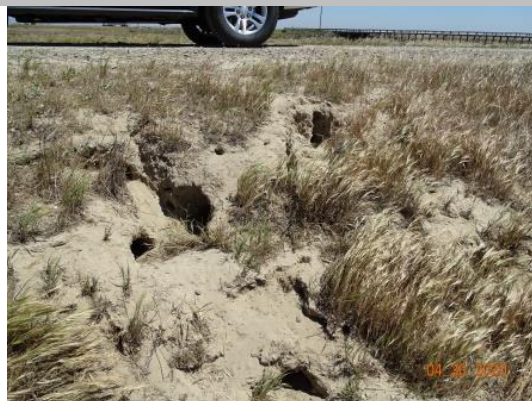
Photo 1 of 1 : FA_2022_NA0010_137_14_20220822_00004.jpg

LM Start	7.39	Rating **	U	Issue No.	14
LM End	7.53	Issue Type +	Ma	Location *	LS
Category	Earthen Levee			GPS Latitude/Longitude	
				Start	End
Item	Animal Control			36.874479 °	36.872503 °
				-120.319831 °	-120.319438 °
DWR ID	DWR_NA0010_18_f_2017_14				
Comment Code					
A3 : No rodents visible, but rodent burrows visible; need to backfill and compact or grout burrows.					
Inspector Comment					
There are several rodent holes noted along the landside slope in this area.

View of rodent burrows in the landside slope. (Spring 2020)

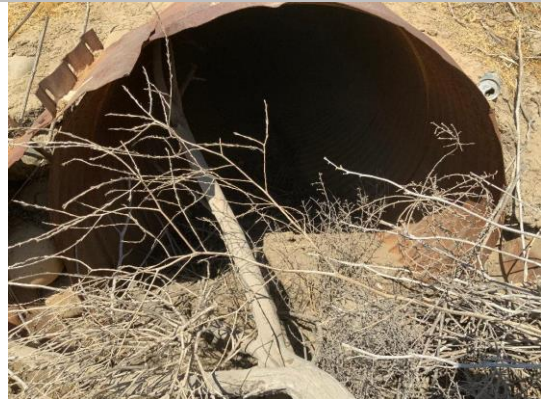
Photo 1 of 1 : UCIP_FA_2022_73468_102096.jpg

Comment Code					
Inspector Comment					
DS_ID:19930 FS_ID:73468 EP_NO: 13548 Repair Type: Non-Urgent EVAL Issue: 11, Maintenance Compliance Issue Crossing Status: Found UCIP Comments: 07/20/2021 The record remains Non-Urgent. No longer debris or sediment inside LS pipe outlet. WS pipe does not appear to be distorted, but has minor vegetation over inlet, recommend removal. The UCIP inspection was completed with GEI staff, P. Espinoza. (H. Dunn – GEI) 04/10/2014 CMP crossing is distorted on waterward side. Debris scattered on landward side. Sediment deposit inside crossing visible from landward side. Recommend removing debris from landward side. (DWR UCIP - O. Magana) FIELD_STRUCT_DESC: 42-inch reinforced concrete (RC) gravity irrigation pipe through the levee, 19.0 feet below the crown. Gate structure on the waterside (WS) shoulder. Pipe section on the WS is made of corrugated metal (CM). Pipe section on the landside (LS) is made of RC. (42-inch RC gravity irrigation pipe authorized under Permit No. 13548, 1983 - New Stone Water District). [Additional Reference(s): DWR Levee Log, 2002, (HLM 7.53)]. FS Date: 7/30/2021 3:01:27 PM

WS view: Closeup of pipe inlet at toe.

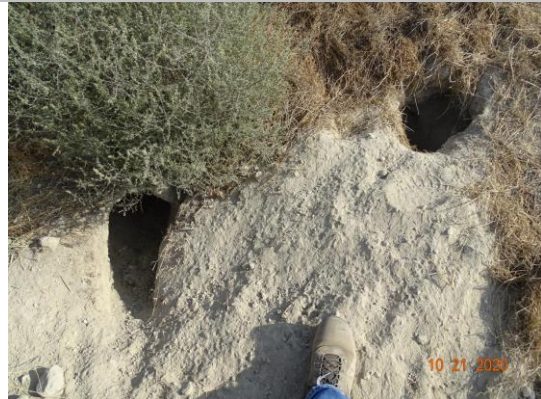
Photo 1 of 1 : FA_2022_NA0010_137_18_20220822_00006.jpg

LM Start	8.89	Rating **	U	Issue No.	18
LM End	8.89	Issue Type +	Ma	Location *	LS
Category	Earthen Levee			GPS Latitude/Longitude	
				Start	End
Item	Animal Control			36.852936 °	36.852936 °
				-120.316451 °	-120.316451 °
DWR ID	DWR_NA0010_18_f_2020_18				
Comment Code					
A3 : No rodents visible, but rodent burrows visible; need to backfill and compact or grout burrows.					
Inspector Comment

Large rodent holes in the landside slope. (Fall 2020)

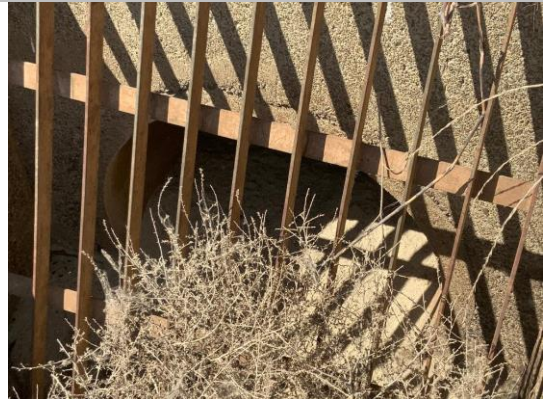
Photo 1 of 1 : UCIP_FA_2022_73470_102110.jpg

Comment Code					
Inspector Comment					
DS_ID:19569 FS_ID:73470 EP_NO: 13049 Repair Type: Non-Urgent EVAL Issue: 11, Maintenance Compliance Issue Crossing Status: Found UCIP Comments: 07/20/2021 The record has been upgraded from No Action Needed to Non-Urgent. LS pipe inlet is across the road and behind barbed wire, could not access, limited inspection. WS pipe outlet has sediment buildup inside, recommend removal. The UCIP inspection was completed with GEI staff, P. Espinoza. (H. Dunn – GEI) FIELD_STRUCT_DESC: 36-inch reinforced concrete (RC) gravity drainage pipe through the levee, 14.8 feet below the crown. Gate structure on the waterside (WS) slope. Standpipe on the WS end. Riprap on the landside (LS) slope. (36-inch RC gravity drainage pipe authorized under Permit No. 13049, 1981 - Newhall Land and Farming Company). [Additional Reference(s): DWR Levee Log, 2002, (HLM 13.37)]. FS Date: 7/20/2021

WS view: Closeup of pipe inlet at toe with sediment buildup.

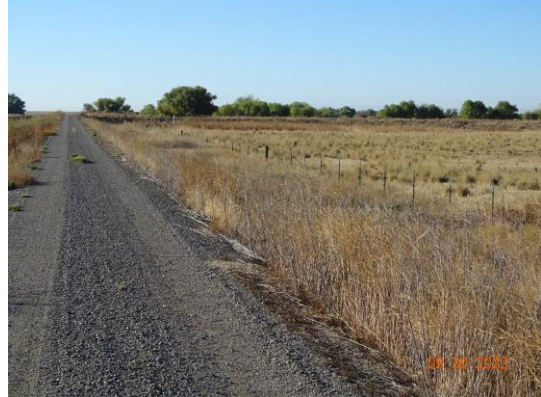
Photo 1 of 1 : FA_2022_NA0010_138_31_20221014_00027.jpg

LM Start	0.09	Rating **	M	Issue No.	31
LM End	1.18	Issue Type +	Ma	Location *	LS
Category	Earthen Levee			GPS Latitude/Longitude	
				Start	End
Item	Vegetation			37.206962 °	37.222167 °
				-120.696268 °	-120.698976 °
DWR ID	DWR_NA0010_22A_f_2022_31				
Comment Code					
V1 : Control annual grass and weeds on the levee slopes and easements.					
Inspector Comment

View of vegetation on the landside slope. (Fall 2022)
