Flood Control Project Maintenance Levee Inspections

Fall 2022 Levee Maintenance Deficiency Summary Report

San Joaquin River Basin

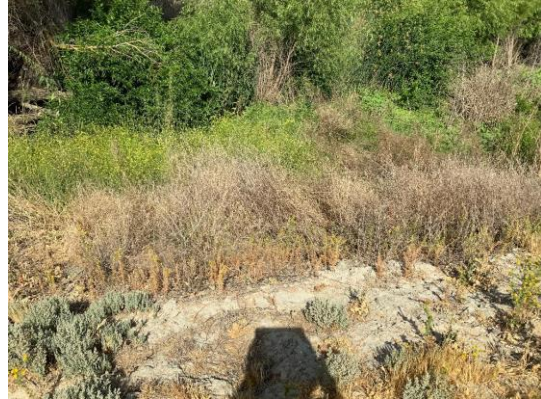
Photo 1 of 2 : UCIP_FA_2022_73507_103856.jpg

Comment Code						
Inspector Comment						
DS_ID:19933 FS_ID:73507 EP_NO: N/A Repair Type: Non-Urgent EVAL Issue: 4b, Safety Issue Crossing Status: Found UCIP Comments: 06/09/2021 The record remains Non-Urgent. Limited inspection of LS due to dense vegetation; recommend removal. Limited inspection on WS due to elevated water level. No pipe inlet or outlet was visible on LS or WS. Riser on WS missing lid, causing a safety hazard. No permit was found authorizing this encroachment. CVFPB will need to review crossing to determine owner. The UCIP inspection was completed with GEI staff, H.Dunn. (P.Espinoza – GEI) 07/19/2016 Gate inside riser appears operable--riser lid damage. Crossing is not visible on LS due to dense vegetation. Recommend clearing dense vegetation along WS and LS slope and repairing riser cover. (O. Magana - DWR UCIP)04/15/2014 No actuator wheel on slide gate at WS shoulder. (W. Wylie - DWR UCIP) FIELD_STRUCT_DESC: 24-inch corrugated metal gravity drainage pipe (CMP) through the levee, 14.8 feet below the crown. Slide gate in a 36-inch CMP riser unit on the waterside (WS) slope. Concrete U-shaped headwall on each end. [Additional Reference(s): DWR Levee Log, 2002, (HLM 0.10). USACE San Joaquin O&M Manual, Unit No. 601, Part No. 1, 1967, Amended in 1978, Revised 20 June 1985, (HLM 0.10). DWR As-Built Specification No. 63-25, Sheet No. 15, 9 May 1963, (HLM 0.10)]. FS Date: 6/9/2021 12:38:00 PM

LS view: Toe from crown, dense vegetation.

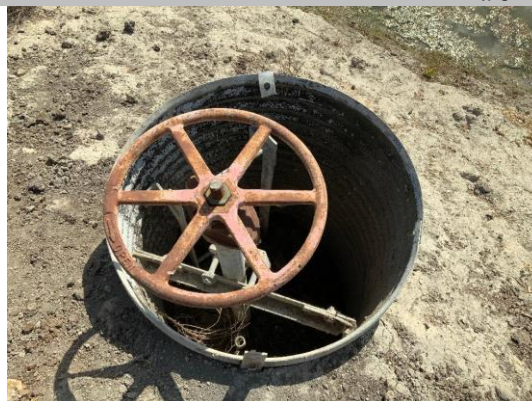
Photo 2 of 2 : UCIP_FA_2022_73507_103855.jpg

LM Start	0.10	Rating **	M	Issue No.	38 (cont)
LM End	0.10	Issue Type +	Ma	Location *	
Category	Supplemental			GPS Latitude/Longitude	
				Start	End
Item	DWR UCIP LMA Responsibility			37.207039 °	37.207039 °
				-120.696255 °	-120.696255 °
DWR ID	19933

WS view: close up of CMP riser on slope.

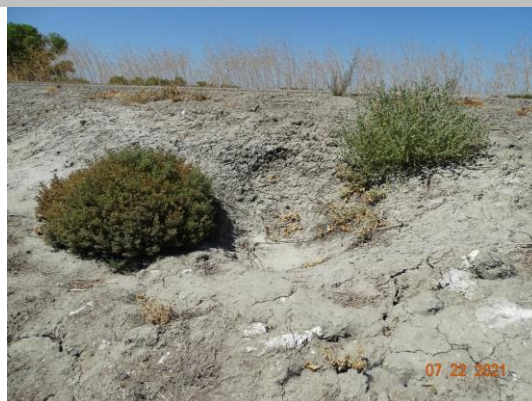
Photo 1 of 1 : FA_2022_NA0010_138_22_20220822_00020.jpg

LM Start	1.04	Rating **	M	Issue No.	22
LM End	1.04	Issue Type +	Ma	Location *	WS
Category	Earthen Levee			GPS Latitude/Longitude	
				Start	End
Item	Slope Stability			37.220281 °	37.220281 °
				-120.698287 °	-120.698287 °
DWR ID	DWR_NA0010_22A_f_2021_22				
Comment Code					
S1 : Repair slope instability.					
Inspector Comment

View of the caving pocket on the levee slope (Fall 2021).

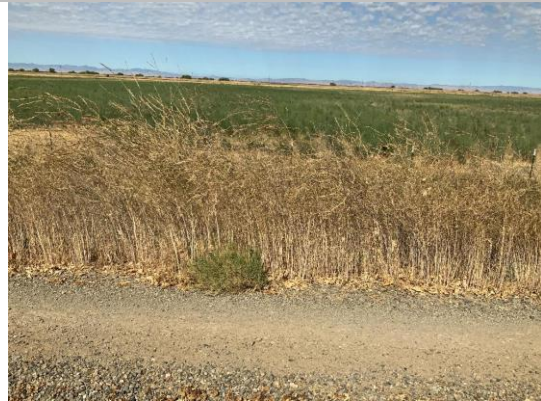
Photo 1 of 2 : UCIP_FA_2022_73517_103906.jpg

Comment Code						
Inspector Comment						
DS_ID:19936 FS_ID:73517 EP_NO: N/A Repair Type: Non-Urgent EVAL Issue: 4b, Safety Issue Crossing Status: Found UCIP Comments: 06/09/2021 The record remains Non-Urgent. Appears abandoned due to headwall not being found on LS. (CMP) riser has no lid, causing a safety hazard; debris visible inside riser, recommend clearing out unless confirmed abandoned. Limited inspection on WS due to water and on LS due to dense vegetation, recommend removal of LS vegetation. No permit was found authorizing this encroachment. CVFPB will need to review crossing to determine owner. The UCIP inspection was completed with GEI staff, H.Dunn. (P.Espinoza – GEI)						
04/15/2014 Slide gate rusted and does not function. Headwall buried at LS toe. Pipe appears abandoned and if so should be done so properly. (W. Wylie - DWR UCIP) FIELD_STRUCT_DESC: 8-inch corrugated metal gravity irrigation pipe (CMP) through the levee, 7.0 feet below the crown. Slide gate in a 36-inch CMP riser unit on the waterside (WS) slope. Concrete headwall on the landside (LS) end. [Additional Reference(s): DWR Levee Log, 2002, (HLM 1.57). USACE San Joaquin O&M Manual, Unit No. 601, Part No. 1, 1967, Amended in 1978, Revised 20 June 1985, (HLM 1.57). DWR As-Built Specification No. 63-25, Sheet No. 16, 9 May 1963, (HLM 1.57)]. FS Date: 6/9/2021 2:54:00 PM

LS view: Toe from crown, dense vegetation.

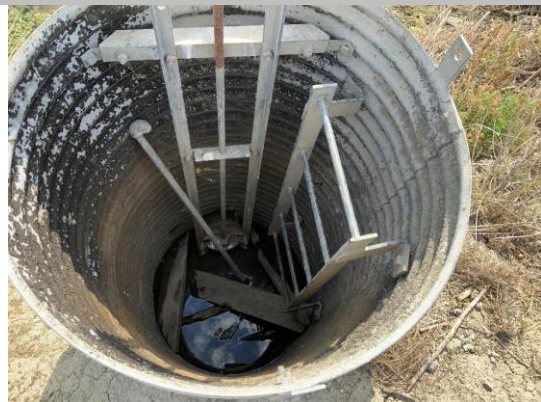
Photo 2 of 2 : UCIP_FA_2022_73517_103903.jpg

WS view: closeup of interior of (CMP) riser.

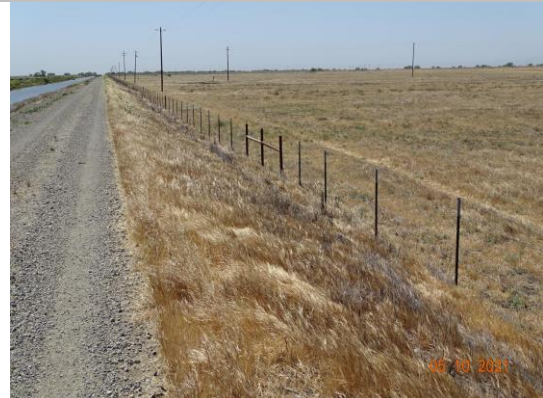
Photo 1 of 1 : FA_2022_NA0010_138_28_20220822_00022.jpg

LM Start	1.75	Rating **	M	Issue No.	28
LM End	2.60	Issue Type +	En	Location *	LS
Category	Earthen Levee			GPS Latitude/Longitude	
				Start	End
Item	Encroachments			37.230585 °	37.242371 °
				-120.702045 °	-120.706371 °
DWR ID	DWR_NA0010_22A_f_2018_28				
Comment Code					
FE : Fence					
Inspector Comment					
A fence is located along the landside toe.

View of fence along landside toe. (Spring 2021)

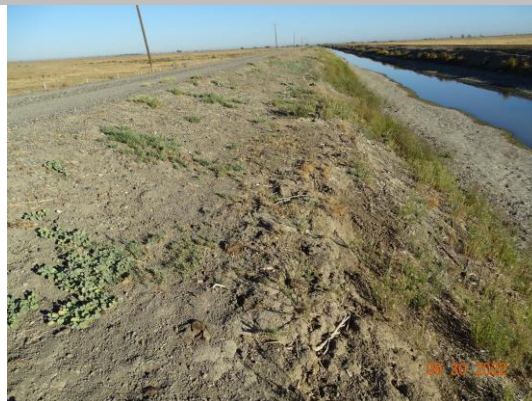
Photo 1 of 1 : FA_2022_NA0010_138_29_20221014_00028.jpg

LM Start	2.25	Rating **	M	Issue No.	29
LM End	2.37	Issue Type +	Ma	Location *	WS
Category	Earthen Levee			GPS Latitude/Longitude	
				Start	End
Item	Erosion / Livestock			37.237050 °	37.238776 °
				-120.704393 °	-120.705028 °
DWR ID	DWR_NA0010_22A_f_2018_29				
Comment Code					
E4 : Repair the levee slope damaged by livestock and prevent large animal access.					
Inspector Comment					
There is slope erosion from livestock, the slope is no longer 3:1.

View of damage to the waterside slope looking downstream. (Fall 2022)

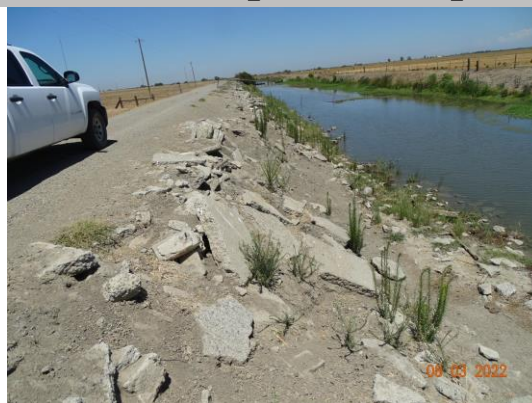
Photo 1 of 1 : SJR2022_NA0010U22RM3.87_3.JPG

LM Start	2.65	Rating **	U	Issue No.	1	
LM End	2.66	Issue Type +	Ma	Location *		
Category	Supplemental			GPS Latitude/Longitude		
				Start		End
Item	DWR Erosion Survey			37.242595 °		37.242595 °
				-120.706470 °		-120.706470 °
DWR ID	NA0010U22RM3.87					
Comment Code						
Inspector Comment						
Site ID: NA0010U22RM3.87						
08/03/2022: From 2021 to present, no significant changes were observed during the annual survey.						
08/18/2020: The site has been covered with loose fill and crushed concrete pieces. The erosion will likely worsen again during the next high water.						
09/12/2019: The erosion has cut into the levee prism and damaged almost half of the levee. The livestock traffic has likely caused the erosion.

8/3/2022: View of the erosion with fill and concrete looking downstream.

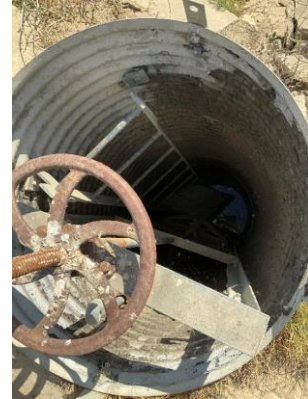
Photo 1 of 1 : UCIP_FA_2022_73518_103912.jpg

Comment Code						
Inspector Comment						
DS_ID:19937 FS_ID:73518 EP_NO: N/A Repair Type: Non-Urgent EVAL Issue: 4b, Safety Issue Crossing Status: Found UCIP Comments: 06/09/2021 The record remains Non-Urgent. Appears abandoned due to no found headwall on LS toe. (CMP) riser missing lid, causing a safety hazard. Slidegate appears to be open; visible water in CMP riser. Limited inspection of WS inlet due to it being underwater at the time of survey. No permit was found authorizing this encroachment. CVFPB will need to review crossing to determine owner. The UCIP inspection was completed with GEI staff, H.Dunn. (PEspinoza – GEI) 04/15/2014 Slide gate does not function and should be repaired. Headwall at LS toe not found. (W. Wylie - DWR UCIP) FIELD_STRUCT_DESC: 24-inch corrugated metal irrigation siphon pipe (CMP) through the levee, 7.5 feet below the crown. Slide gate in a 36-inch CMP riser unit on the waterside (WS) slope. Concrete U-shaped headwall on the landside (LS) end. [Additional Reference(s): DWR Levee Log, 2002, (HLM 2.72). USACE San Joaquin O&M Manual, Unit No. 601, Part No. 1, 1967, Amended in 1978, Revised 20 June 1985, (HLM 2.72). DWR As-Built Specification No. 63-25, Sheet No. 17, 9 May 1963, (HLM 2.72)]. FS Date: 6/9/2021 3:03:00 PM

WS view: Water visible in riser on slope.

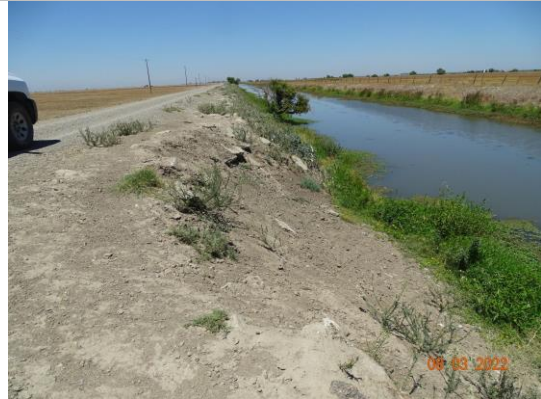
Photo 1 of 1 : SJR2022_NA0010U22RM3.65_2.JPG

LM Start	2.87	Rating **	U	Issue No.	4
LM End	2.88	Issue Type +	Ma	Location *	
Category	Supplemental			GPS Latitude/Longitude	
				Start	End
Item	DWR Erosion Survey			37.245536 °	37.245536 °
				-120.708119 °	-120.708119 °
DWR ID	NA0010U22RM3.65				
Comment Code					
Inspector Comment					
Site ID: NA0010U22RM3.65 08/03/2022: From 2021 to present, no significant changes were observed during the annual survey. 08/18/2020: No vegetation visible in the area of the erosion. Noticed some crushed concrete pieces on the levee slope and a small amount of loose fill. 09/12/2019: The erosion has damaged entire levee slope. The livestock traffic likely has caused the erosion.

8/3/2022: View of the erosion looking downstream.

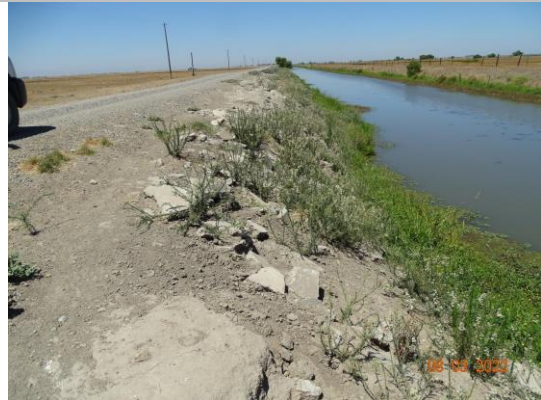
Photo 1 of 1 : SJR2022_NA0010U22RM3.56_2.JPG

LM Start	2.96	Rating **	M	Issue No.	7
LM End	2.97	Issue Type +	Ma	Location *	
Category	Supplemental			GPS Latitude/Longitude	
				Start	End
Item	DWR Erosion Survey			37.246408 °	37.246408 °
				-120.709197 °	-120.709197 °
DWR ID	NA0010U22RM3.56				
Comment Code					
Inspector Comment					
Site ID: NA0010U22RM3.56 08/03/2022: From 2021 to present, no significant changes were observed during the annual survey. 08/18/2020: The erosion has been covered with loose fill and crushed concrete pieces. A nearly vertical slope remains at the levee toe in some sections. The site will likely worsen again during the next high water. 09/12/2019: The erosion has damaged entire levee slope. The livestock activity likely has caused the erosion.

8/3/2022: View of the erosion and crushed concrete on the slope.

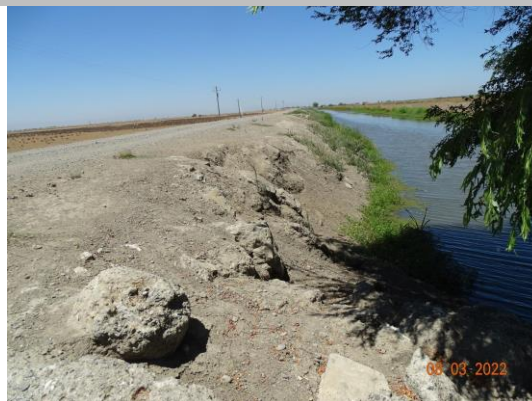
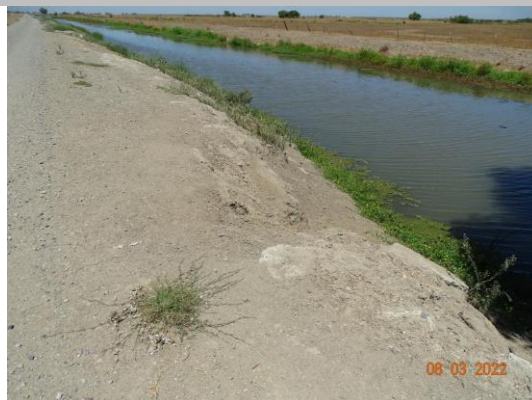
Photo 1 of 2 : SJR2022_NA0010U22RM3.38_2.JPG

09/12/2019: The erosion has damaged the entire levee slope. Livestock activity likely has caused the erosion.

8/3/2022: View of the erosion looking downstream.

8/3/2022: Close-up view of the erosion.

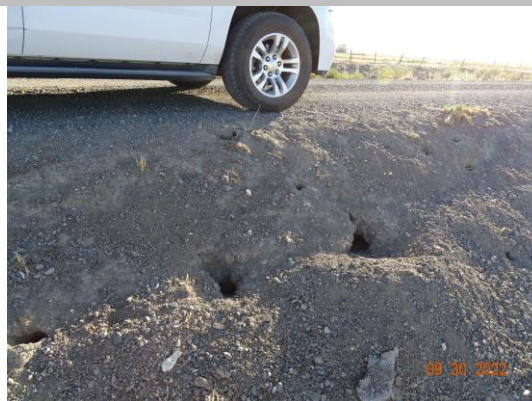
Photo 1 of 1 : FA_2022_NA0010_138_30_20221014_00029.jpg

LM Start	3.38	Rating **	M	Issue No.	30
LM End	3.38	Issue Type +	Ma	Location *	LS
Category	Earthen Levee			GPS Latitude/Longitude	
				Start	End
Item	Animal Control			37.250687 °	37.250687 °
				-120.714559 °	-120.714559 °
DWR ID	DWR_NA0010_22A_f_2022_30				
Comment Code					
A3 : No rodents visible, but rodent burrows visible; need to backfill and compact or grout burrows.					
Inspector Comment

View of rodent holes in the landside slope. (Fall 2022)

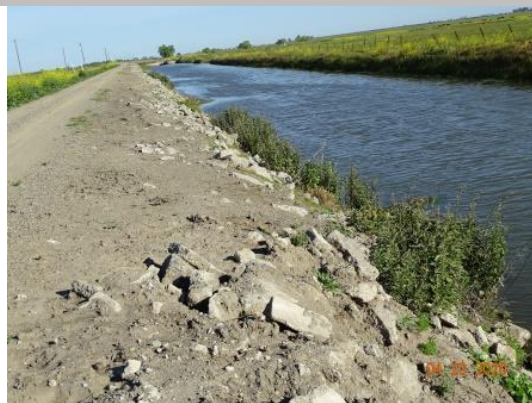
Photo 1 of 1 : FA_2022_NA0010_138_34_20220822_00024.jpg

LM Start	3.44	Rating **	U	Issue No.	34
LM End	3.44	Issue Type +	Ma	Location *	WS
Category	Earthen Levee			GPS Latitude/Longitude	
				Start	End
Item	Erosion / Livestock			37.251370 °	37.251370 °
				-120.715344 °	-120.715344 °
DWR ID	DWR_NA0010_22A_f_2018_34				
Comment Code					
E4 : Repair the levee slope damaged by livestock and prevent large animal access.					
Inspector Comment					
Broken concrete was placed on the waterside slope to prevent erosion from livestock. Concrete with rebar should be removed.

Fill and concrete were placed to repair erosion on the waterside slope. Concrete with rebar should be removed. (Spring 2020)

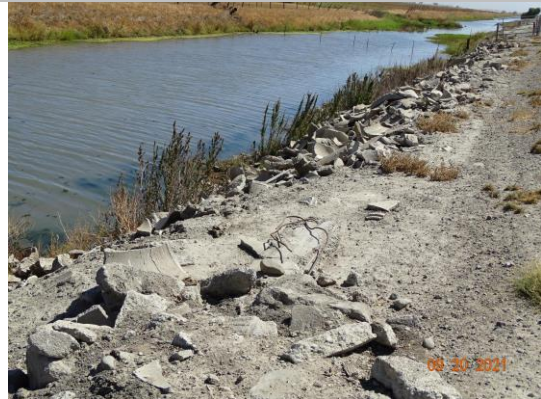
Photo 1 of 1 : FA_2022_NA0010_138_35_20220822_00025.jpg

LM Start	3.47	Rating **	U	Issue No.	35
LM End	3.50	Issue Type +	Ma	Location *	WS
Category	Earthen Levee			GPS Latitude/Longitude	
				Start	End
Item	Erosion / Livestock			37.251621 °	37.251978 °
				-120.715649 °	-120.716143 °
DWR ID	DWR_NA0010_22A_f_2018_35				
Comment Code					
E4 : Repair the levee slope damaged by livestock and prevent large animal access.					
Inspector Comment					
Waterside slope erosion is from livestock activity. Slope stabilized with broken concrete. Concrete with rebar in it should be removed.

Fill and concrete placed on the waterside slope. Rebar should be removed for safety. (Fall 2021)

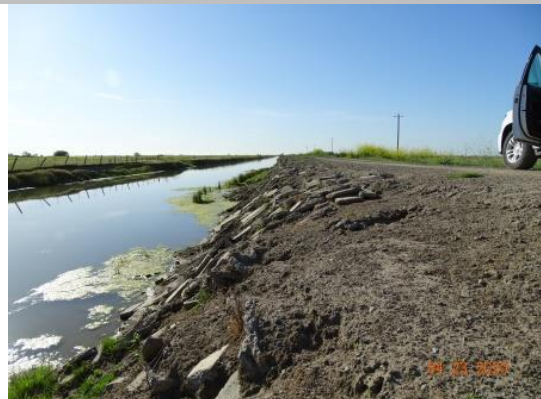
Photo 1 of 1 : FA_2022_NA0010_138_9_20220822_00013.jpg

LM Start	3.64	Rating **	A/W	Issue No.	9
LM End	3.69	Issue Type +	Ma	Location *	WS
Category	Earthen Levee			GPS Latitude/Longitude	
				Start	End
Item	Erosion / Livestock			37.253362 °	37.253862 °
				-120.717873 °	-120.718507 °
DWR ID	DWR_NA0010_22A_f_2016_9				
Comment Code					
E4 : Repair the levee slope damaged by livestock and prevent large animal access.					
Inspector Comment					
Broken concrete has been placed to limit further erosion caused by livestock. Continue to monitor.

View of waterside slope looking upstream. (Spring 2020)

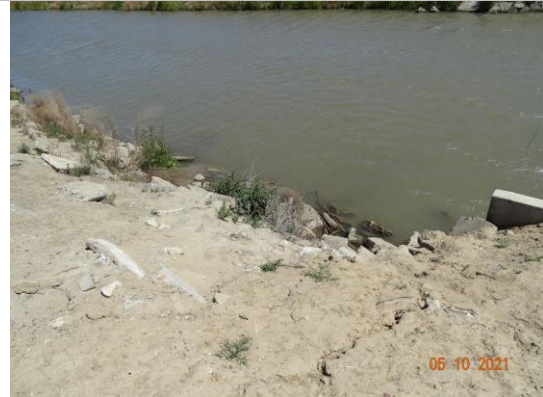
Photo 1 of 1 : FA_2022_NA0010_138_14_20220822_00016.jpg

LM Start	3.82	Rating **	M	Issue No.	14
LM End	3.82	Issue Type +	Ma	Location *	WS
Category	Earthen Levee			GPS Latitude/Longitude	
				Start	End
Item	Erosion / Livestock			37.255239 °	37.255239 °
				-120.720142 °	-120.720142 °
DWR ID	DWR_NA0010_22A_f_2017_14				
Comment Code					
E4 : Repair the levee slope damaged by livestock and prevent large animal access.					
Inspector Comment					
Broken concrete previously placed to stabilize the slope has washed out.

Damage to the waterside slope. (Spring 2021)

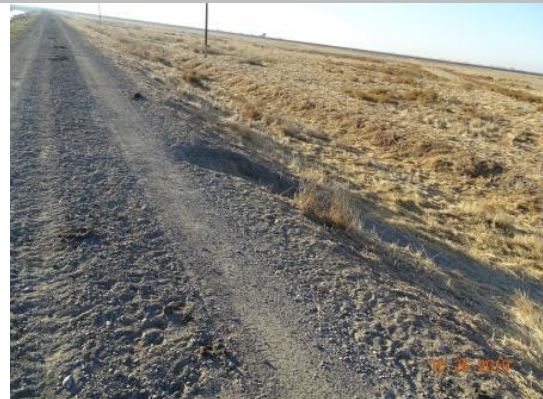
Photo 1 of 1 : FA_2022_NA0010_138_15_20220822_00017.jpg

LM Start	4.11	Rating **	M	Issue No.	15
LM End	4.11	Issue Type +	Ma	Location *	LS
Category	Earthen Levee			GPS Latitude/Longitude	
				Start	End
Item	Erosion / Livestock			37.258353 °	37.258353 °
				-120.723824 °	-120.723824 °
DWR ID	DWR_NA0010_22A_f_2019_15				
Comment Code					
E4 : Repair the levee slope damaged by livestock and prevent large animal access.					
Inspector Comment

View of erosion in the landside slope and shoulder from livestock traffic. (Fall 2019)

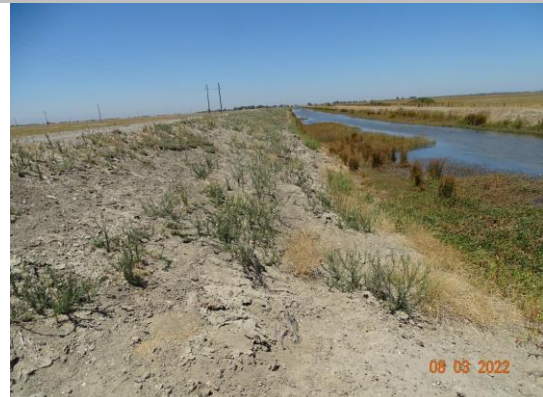
Photo 1 of 1 : SJR2022_NA0010_22A_f_2018_37_2.JPG

LM Start	4.26	Rating **	U	Issue No.	10
LM End	4.30	Issue Type +	Ma	Location *	
Category	Supplemental			GPS Latitude/Longitude	
				Start	End
Item	DWR Erosion Survey			37.260111 °	37.260111 °
				-120.725900 °	-120.725900 °
DWR ID	NA0010U22RM2.25				
Comment Code					
Inspector Comment					
Site ID: NA0010U22RM2.25					
08/03/2022: From 2020 to present, no significant changes were observed during the annual survey.					
09/12/2019: Erosion has developed into the lower levee slope. Loose material was observed at the site.

8/3/2022: View of the erosion looking downstream.

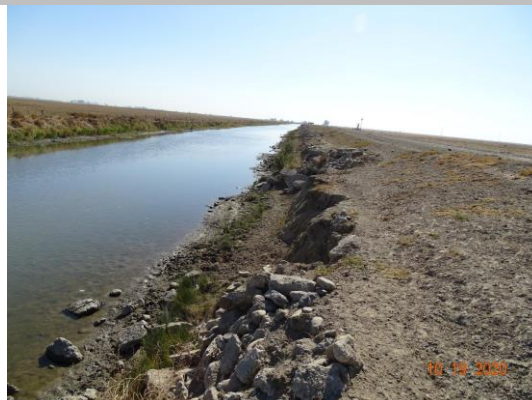
Photo 1 of 1 : FA_2022_NA0010_138_37_20220822_00026.jpg

LM Start	4.30	Rating **	U	Issue No.	37
LM End	5.11	Issue Type +	Ma	Location *	WS
Category	Earthen Levee			GPS Latitude/Longitude	
				Start	End
Item	Erosion / Livestock			37.260111 °	37.268135 °
				-120.725900 °	-120.737130 °
DWR ID	DWR_NA0010_22A_f_2018_37				
Comment Code					
E4 : Repair the levee slope damaged by livestock and prevent large animal access.					
Inspector Comment					
Erosion is cutting into the waterside slope. Some sections have been stabilized with cobble stone and broken concrete.

View of waterside slope damage looking upstream. (Fall 2020)

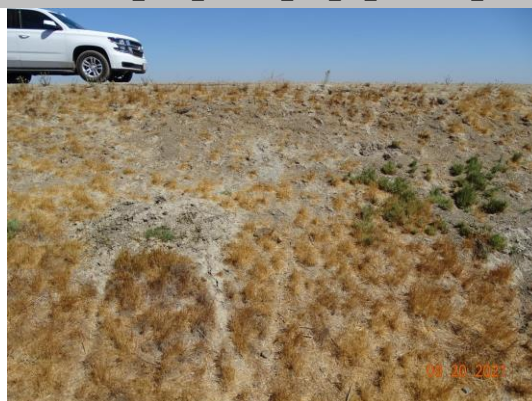
Photo 1 of 1 : FA_2022_NA0010_138_21_20220822_00019.jpg

LM Start	4.42	Rating **	M	Issue No.	21
LM End	4.42	Issue Type +	Ma	Location *	LS
Category	Earthen Levee			GPS Latitude/Longitude	
				Start	End
Item	Animal Control			37.261573 °	37.261573 °
				-120.727622 °	-120.727622 °
DWR ID	DWR_NA0010_22A_f_2021_21				
Comment Code					
A3 : No rodents visible, but rodent burrows visible; need to backfill and compact or grout burrows.					
Inspector Comment					
District has placed a bait station at the location.

View of displaced earth and rodent holes in the landside slope. (Fall 2021)

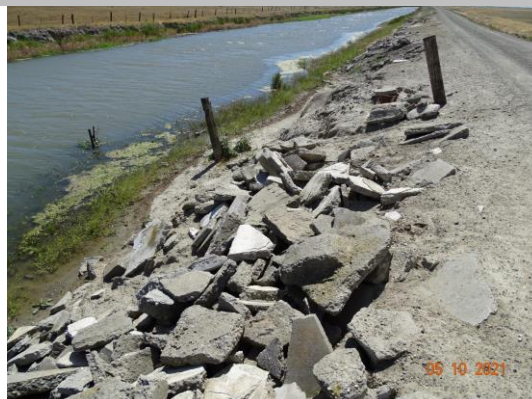
Photo 1 of 1 : FA_2022_NA0010_138_8_20220822_00012.jpg

LM Start	4.87	Rating **	A/W	Issue No.	8
LM End	4.87	Issue Type +	Ma	Location *	WS
Category	Earthen Levee			GPS Latitude/Longitude	
				Start	End
Item	Erosion / Livestock			37.265813 °	37.265813 °
				-120.733748 °	-120.733748 °
DWR ID	DWR_NA0010_22A_f_2016_8				
Comment Code					
E4 : Repair the levee slope damaged by livestock and prevent large animal access.					
Inspector Comment					
Levee damage caused by animal traffic. Several sites repaired with broken concrete. Continue to monitor.

Slope damage repaired with concrete rubble on the waterside slope and shoulder. (Spring 2021)

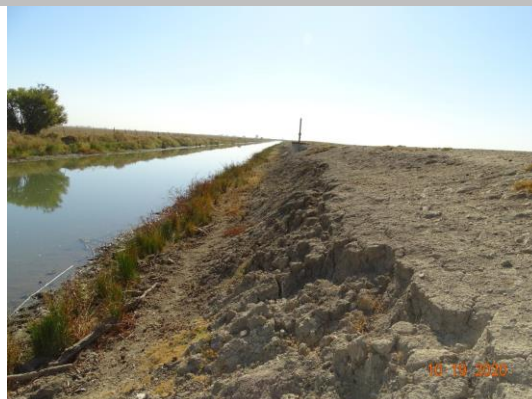
Photo 1 of 1 : FA_2022_NA0010_138_6_20220822_00009.jpg

LM Start	5.12	Rating **	M	Issue No.	6
LM End	5.49	Issue Type +	Ma	Location *	WS
Category	Earthen Levee			GPS Latitude/Longitude	
				Start	End
Item	Erosion / Livestock			37.268236 °	37.272262 °
				-120.737210 °	-120.741778 °
DWR ID	DWR_NA0010_22A_s_2022_6				
Comment Code					
E4 : Repair the levee slope damaged by livestock and prevent large animal access.					
Inspector Comment					
Slope damage is caused by livestock on waterside toe.

Looking southeast at livestock erosion on waterward toe. (Fall 2020)

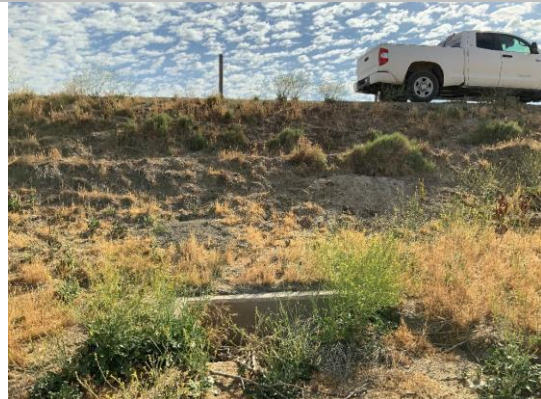
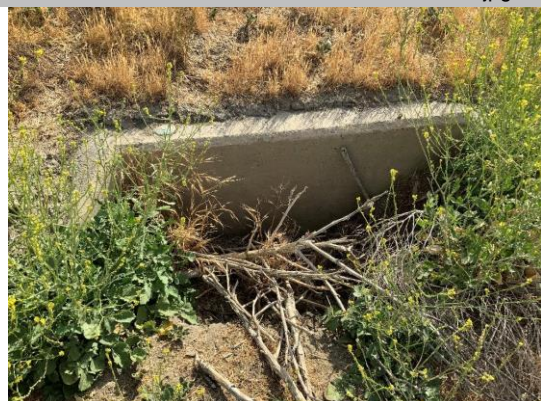
Photo 1 of 2 : UCIP_FA_2022_73519_103919.jpg

Comment Code						
Inspector Comment						
DS_ID:19938 FS_ID:73519 EP_NO: N/A Repair Type: Non-Urgent EVAL Issue: 11, Maintenance Compliance Issue Crossing Status: Found UCIP Comments: 06/09/2021 The record remains Non-Urgent. Appears abandoned due to the LS headwall being buried in sediment and debris buildup, recommend clearing out. Inlet pipe on WS is not visible due to water in channel at the time of the survey. Limited inspection on both WS and LS pipe inlet/outlet. No permit was found authorizing this encroachment. CVFPB will need to review crossing to determine owner. The UCIP inspection was completed with GEI staff, H.Dunn. (P.Espinoza – GEI) 04/15/2014 Need to contact owner. Pipe silted in on LS toe. Appears abandoned and if so should be done so properly. (W. Wylie - DWR UCIP) FIELD_STRUCT_DESC: *ABANDONED* 48-inch corrugated metal irrigation siphon pipe (CMP) through the levee, 10.0 feet below the crown. Slide gate in a 60-inch CMP riser unit on the waterside (WS) slope. Concrete headwall on the landside (LS) end. WS end capped with a 0.25-inch steel plate. [Additional Reference(s): DWR Levee Log, 2002, (HLM 5.48). USACE San Joaquin O&M Manual, Unit No. 601, Part No. 1, 1967, Amended in 1978, Revised 20 June 1985, (HLM 5.48). DWR As-Built Specification No. 63-25, Sheet No. 19, 9 May 1963, (HLM 5.48)]. FS Date: 6/9/2021 3:14:00 PM

LS view: slope and buried headwall at toe.

LS view: Closeup of buried concrete headwall at toe.

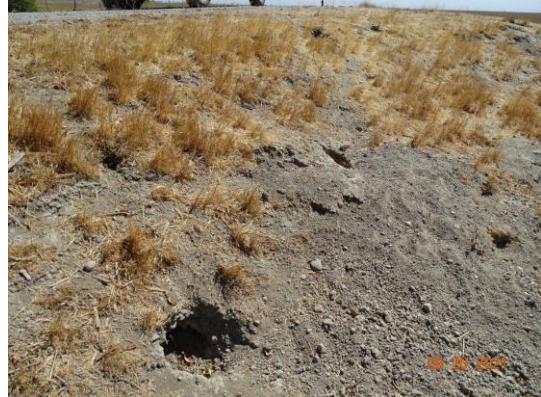
Photo 1 of 1 : FA_2022_NA0010_138_20_20220822_00018.jpg

LM Start	5.50	Rating **	M	Issue No.	20
LM End	5.50	Issue Type +	Ma	Location *	LS
Category	Earthen Levee			GPS Latitude/Longitude	
				Start	End
Item	Animal Control			37.272345 °	37.272345 °
				-120.741883 °	-120.741883 °
DWR ID	DWR_NA0010_22A_f_2021_20				
Comment Code					
A3 : No rodents visible, but rodent burrows visible; need to backfill and compact or grout burrows.					
Inspector Comment

View of rodent holes in the landside slope looking upstream. (Fall 2021)

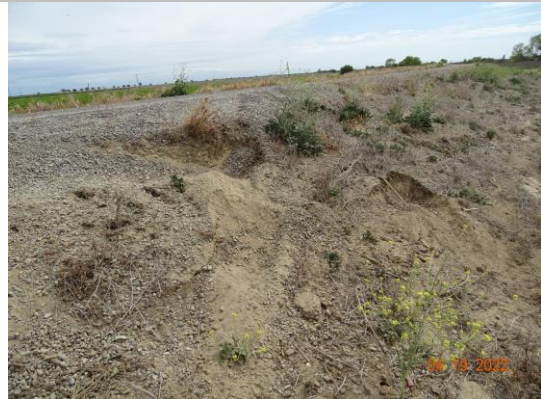
LM Start	0.60	Rating **	M	Issue No.	1187 (cont)
LM End	0.60	Issue Type +	Ma	Location *	
Category	Supplemental			GPS Latitude/Longitude	
				Start	End
Item	DWR UCIP LMA Responsibility			37.341507 °	37.341507 °
				-120.961283 °	-120.961283 °
DWR ID	19583

Waterway	Bank	Unit Miles	Inspection Start/End	Inspector
Unit No. 01 San Joaquin River	Right	22.52	09/20/2022 09/20/2022	Corey Fujitani

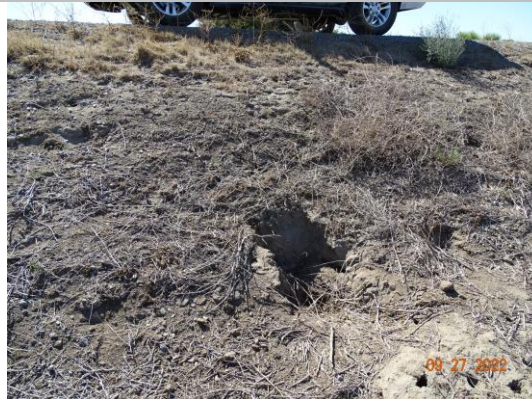
LM Start	0.85	Rating **	M	Issue No.	1188
LM End	0.85	Issue Type +	Ma	Location *	
Category	Supplemental			GPS Latitude/Longitude	
				Start	End
Item	DWR UCIP LMA Responsibility			37.339829 °	37.339829 °
				-120.958621 °	-120.958621 °
DWR ID	19584

Waterway	Bank	Unit Miles	Inspection Start/End	Inspector
Unit No. 01 San Joaquin River	Right	22.52	09/20/2022 09/20/2022	Corey Fujitani

LM Start	0.85	Rating **	M	Issue No.	1188 (cont)
LM End	0.85	Issue Type +	Ma	Location *

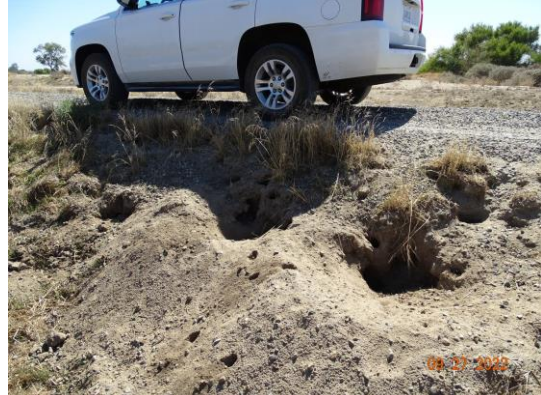
Lower San Joaquin Levee District

Levee Inspection Report By Mile - Fall 2022

LM Start	1.67	Rating **	M	Issue No.	1193 (cont)
LM End	1.67	Issue Type +	Ma	Location *	
Category	Supplemental			GPS Latitude/Longitude	
				Start	End
Item	DWR UCIP LMA Responsibility			37.336459 °	37.336459 °
				-120.944803 °	-120.944803 °
DWR ID	19589

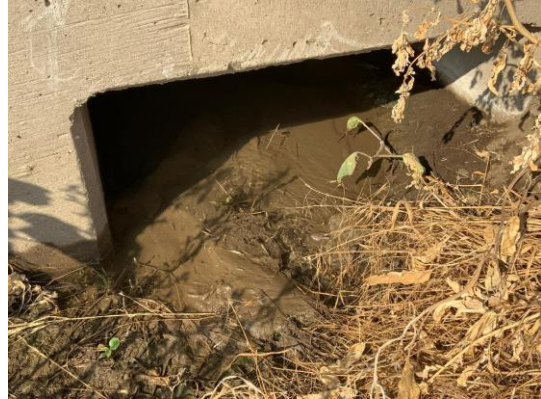
Photo 2 of 3 : UCIP_FA_2022_70646_90615.jpg

LM Start	1.95	Rating **	M	Issue No.	1195 (cont)
LM End	1.95	Issue Type +	Ma	Location *	
Category	Supplemental		GPS Latitude/Longitude		
			Start	End	
Item	DWR UCIP LMA Responsibility		37.334377 °	37.334377 °	
			-120.940397 °	-120.940397 °	
DWR ID	19591

LS view: Pipe and headwall at LS toe

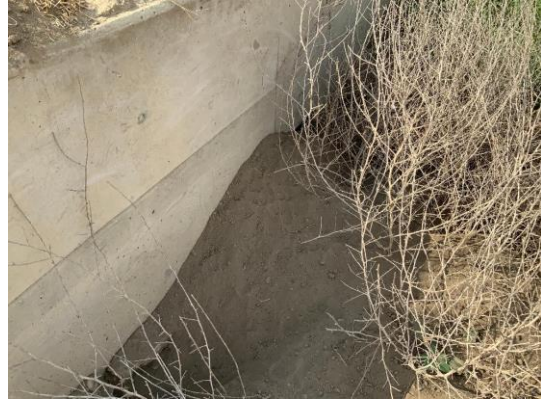
WS view: Pipe and flapgate visible on WS toe

LM Start	2.06	Rating **	U	Issue No.	1196 (cont)
LM End	2.06	Issue Type +	Ma	Location *	
Category	Supplemental		GPS Latitude/Longitude		
			Start	End	
Item	DWR UCIP LMA Responsibility		37.333653 °	37.333653 °	
			-120.938770 °	-120.938770 °	
DWR ID	19570

Photo 3 of 3 : UCIP_FA_2022_70647_90619.jpg

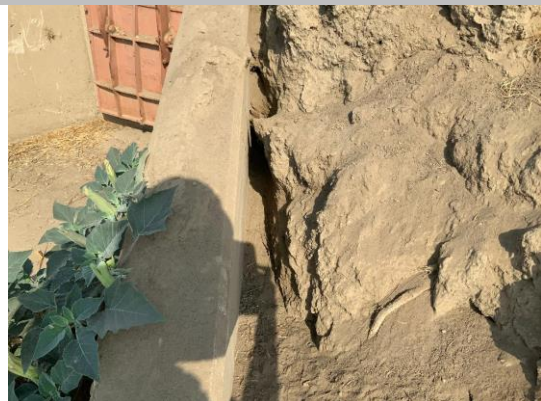
LM Start	2.20	Rating **	N	Issue No.	110
LM End	2.20	Issue Type +	Ma	Location *	LS
Category	Earthen Levee			GPS Latitude/Longitude	
				Start	End
Item	Trim / Thin Trees			37.331820 °	37.331820 °
				-120.937605 °	-120.937605 °
DWR ID	DWR_NA0010_01_f_2018_110				
Comment Code					
T5 : Tree stumps.					
Inspector Comment					
Tree stump on landside slope should be removed.

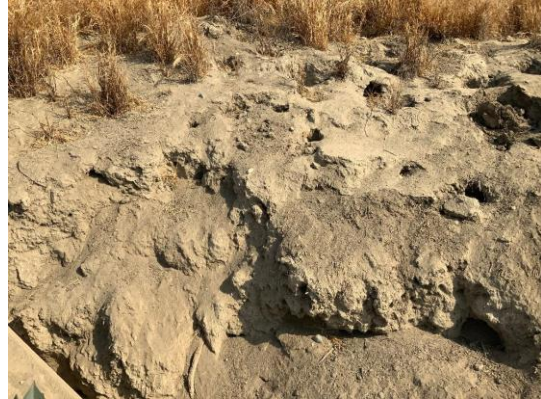
Lower San Joaquin Levee District

LM Start	2.22	Rating **	M	Issue No.	1197	
LM End	2.22	Issue Type +	Ma	Location *		
Category	Supplemental			GPS Latitude/Longitude		
				Start		End
Item	DWR UCIP LMA Responsibility			37.331611 °	37.331611 °	
				-120.937455 °	-120.937455 °	
DWR ID	19571

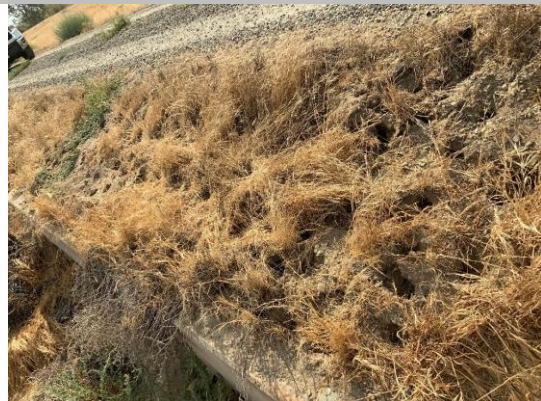
Photo 1 of 2 : UCIP_FA_2022_73585_102681.jpg

DS_ID:19941
 FS_ID:73585
 EP_NO: N/A
 Repair Type: Non-Urgent
 EVAL Issue: 11, Maintenance Compliance Issue
 Crossing Status: Found
 UCIP Comments: 07/19/2021 The record remains Non-Urgent. LS pipe inlet has sediment buildup inside, recommend removal. Extensive burrows above the LS headwall slope. No permit was found authorizing this encroachment. CVFPB will need to review crossing to determine owner. The UCIP inspection was completed with GEI staff, P. Espinoza. (H. Dunn – GEI) 04/03/2014 Dense vegetation limits the inspector's visibility to identify signs of pipe failure (leaks) along the landward slope. Recommend removing vegetation along pipe alignment to conduct proper inspection of structure. (W. Wylie - DWR UCIP)
 FIELD_STRUCT_DESC: 30-inch by 30-inch square reinforced concrete box gravity drainage culvert (RCBC) through the levee, 5.6 feet below the crown. Flap gate on the waterside (WS) end. Concrete headwall on the landside (LS) end. Concrete U-shaped headwall on the WS end.

LS view: Burrow holes above headwall.

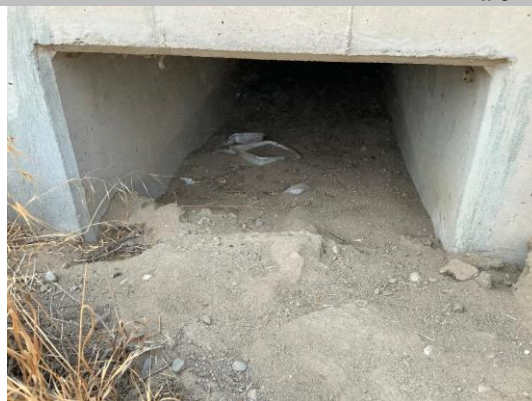
Photo 2 of 2 : UCIP_FA_2022_73585_102675.jpg

LM Start	8.52	Rating **	M	Issue No.	73 (cont)
LM End	8.52	Issue Type +	Ma	Location *	
Category	Supplemental			GPS Latitude/Longitude	
				Start	End
Item	DWR UCIP LMA Responsibility			36.794108 °	36.794108 °
				-120.178171 °	-120.178171 °
DWR ID	19941

LS view: Closeup of pipe inlet at toe with sediment buildup.

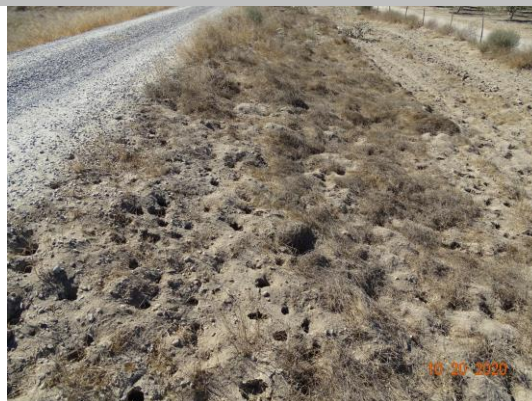
Photo 1 of 1 : FA_2022_NA0010_139_29_20220822_00008.jpg

LM Start	8.55	Rating **	U	Issue No.	29
LM End	8.66	Issue Type +	Ma	Location *	LS
Category	Earthen Levee			GPS Latitude/Longitude	
				Start	End
Item	Animal Control			36.794284 °	36.795288 °
				-120.177783 °	-120.176146 °
DWR ID	DWR_NA0010_23_f_2020_29				
Comment Code					
A3 : No rodents visible, but rodent burrows visible; need to backfill and compact or grout burrows.					
Inspector Comment

Several rodent holes observed along this section of the landside slope.
(Fall 2020)

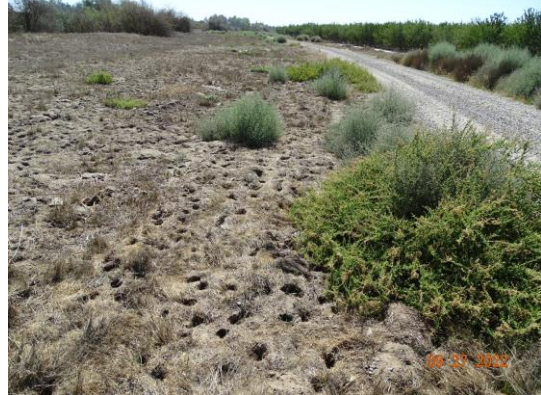
Photo 1 of 1 : FA_2022_NA0010_139_25_20221014_00019.jpg

LM Start	8.97	Rating **	M	Issue No.	25
LM End	8.97	Issue Type +	Ma	Location *	WS
Category	Earthen Levee			GPS Latitude/Longitude	
				Start	End
Item	Animal Control			36.799606 °	36.799606 °
				-120.175395 °	-120.175395 °
DWR ID	DWR_NA0010_23_f_2016_25				
Comment Code					
A3 : No rodents visible, but rodent burrows visible; need to backfill and compact or grout burrows.					
Inspector Comment					
There are rodent holes on the waterside shoulder.

Several rodent holes observed on the waterside slope in this section.
(Fall 2022)

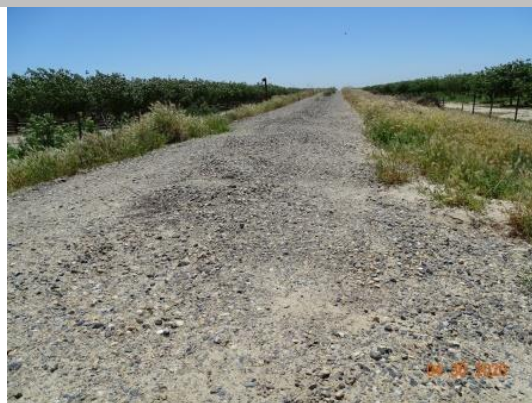
Photo 1 of 1 : FA_2022_NA0010_139_65_20220822_00013.jpg

LM Start	9.74	Rating **	M	Issue No.	65
LM End	9.74	Issue Type +	Ma	Location *	CR
Category	Earthen Levee			GPS Latitude/Longitude	
				Start	End
Item	Crown Surface / Depressions / Rutting			36.807603 °	36.807603 °
				-120.168825 °	-120.168825 °
DWR ID	DWR_NA0010_23_s_2019_65				
Comment Code					
C2 : Repair depressions or ruts in the crown or slope.					
Inspector Comment

Depressions forming in the levee crown. (Spring 2020)

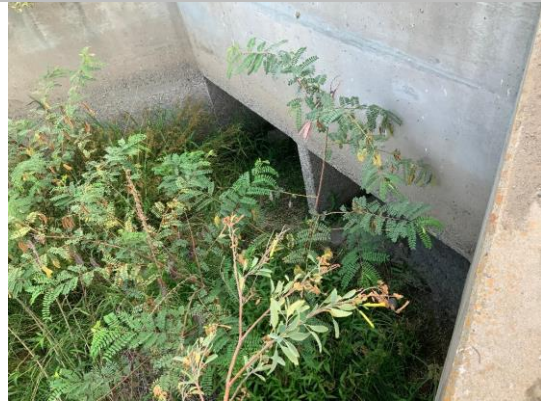
Photo 1 of 2 : UCIP_FA_2022_77382_102710.jpg

Comment Code					
Inspector Comment					
DS_ID:19943 FS_ID:77382 EP_NO: N/A Repair Type: Urgent EVAL Issue: 3a, Flood Risk Crossing Status: Found UCIP Comments: 08/31/2022 Crossing open on both ends with no way to close it as the gates do not work: urgent. (A. McDonald - DWR UCIP)07/19/2021 The record remains Non-Urgent. Limited access to both LS and WS due to steep slopes and vegetation. Both WS outlet and LS inlet have sediment buildup, recommend clearing out. No permit was found authorizing this encroachment. CVFPB will need to review crossing to determine owner. This portion of the levee has a levee prism less than 3 feet, appears to be high ground. The UCIP inspection was completed with GEI staff, P. Espinoza. (H. Dunn – GEI)					
11/01/2018 Limited access to both LS and WS; assumed slide gates are still non-functional; Crossing has been downgraded from Urgent to Non-Urgent due to re-classification of damage slide gates. (O. Magana - DWR UCIP)07/20/2016 No change--same as previous inspection. (O. Magana - DWR UCIP)04/03/2014 Slide gate not functional. Slide gate channels heavily corroded (exfoliated) and likely impact functionality/structural integrity of gate. (W. Wylie - DWR UCIP) FIELD_STRUCT_DESC: [Gravelly Ford Canal Irrigation Structure] 1 of 2: 48-inch by 63-inch reinforced concrete box gravity irrigation culvert (RCBC) through the levee, 10.0 feet below the crown. Concrete U-shaped headwall on each end. Gear pedestal slide gate with wall bracket on the waterside (WS) headwall. 10-foot-long cobble revetted outlet channel. Guardrail on each shoulder. Slide gates on the WS. [Additional Reference(s): DWR Levee Log, 2002, (HLM 9.76). USACE San Joaquin O&M Manual, Unit No. 601, Part No. 1, 1967, Amended in 1978, Revised 20 June 1985, (HLM 9.76). DWR As-Built Specification No. 65-30, Sheet No. 16, 27 April 1965, (HLM 9.76)]. FS Date: 7/19/2021

LS view: Closeup of inlets at toe with sediment buildup.

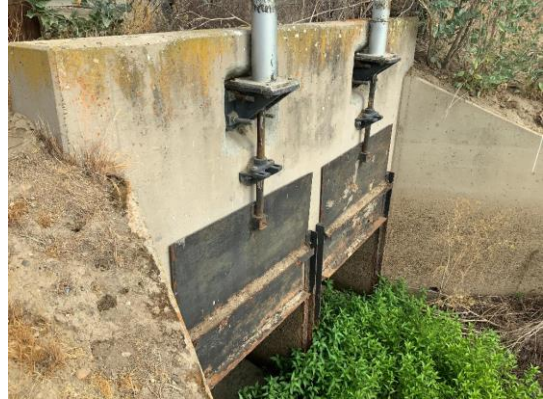
Photo 2 of 2 : UCIP_FA_2022_77382_102713.jpg

LM Start	9.75	Rating **	U	Issue No.	74 (cont)
LM End	9.75	Issue Type +	En	Location *	
Category	Supplemental			GPS Latitude/Longitude	
				Start	End
Item	DWR UCIP Field Study			36.807768 °	36.807768 °
				-120.168848 °	-120.168848 °
DWR ID	19943

WS view: Closeup of slidegates at toe.

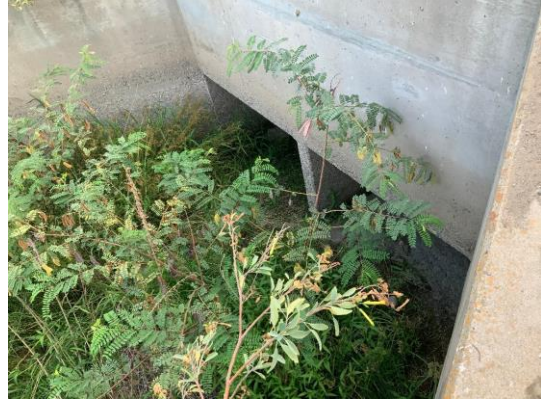
Photo 1 of 2 : UCIP_FA_2022_77383_102717.jpg

Comment Code					
Inspector Comment					
DS_ID:19980 FS_ID:77383 EP_NO: N/A Repair Type: Urgent EVAL Issue: 3a, Flood Risk Crossing Status: Found UCIP Comments: 08/31/2022 Crossing open on both ends with no way to close it as the gates do not work: urgent. (A. McDonald - DWR UCIP)07/19/2021 The record remains Non-Urgent. Limited access to both LS and WS due to steep slopes and vegetation. Both WS outlet and LS inlet have sediment buildup, recommend clearing out. No permit was found authorizing this encroachment. CVFPB will need to review crossing to determine owner. This portion of the levee has a levee prism less than 3 feet, appears to be high ground. The UCIP inspection was completed with GEI staff, P. Espinoza. (H. Dunn – GEI)					
11/01/2018 Limited access to both LS and WS; assumed slide gates are still non-functional; Crossing has been downgraded from Urgent to Non-Urgent due to re-classification of damage slide gates. (O. Magana - DWR UCIP)07/20/2016 No change--same as previous inspection. (O. Magana - DWR UCIP)04/03/2014 Slide gate not functional. Slide gate channels heavily corroded (exfoliated) and likely impact functionality/structural integrity of gate. (W. Wylie - DWR UCIP) FIELD_STRUCT_DESC: [Gravelly Ford Canal Irrigation Structure] 2 of 2: 48-inch by 63-inch reinforced concrete box gravity irrigation culvert (RCBC) through the levee, 10.0 feet below the crown. Concrete U-shaped headwall on each end. Gear pedestal slide gate with wall bracket on the waterside (WS) headwall. 10-foot-long cobble revetted outlet channel. Guardrail on each shoulder. Slide gates on the WS. [Additional Reference(s): DWR Levee Log, 2002, (HLM 9.76). USACE San Joaquin O&M Manual, Unit No. 601, Part No. 1, 1967, Amended in 1978, Revised 20 June 1985, (HLM 9.76). DWR As-Built Specification No. 65-30, Sheet No. 16, 27 April 1965, (HLM 9.76)]. FS Date: 7/19/2021

LS view: Closeup of pipe inlets at toe with sediment buildup.

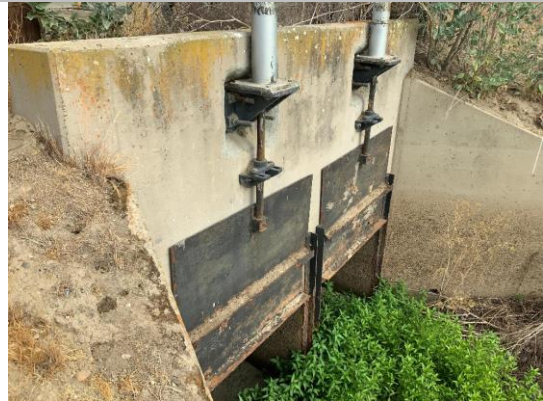
Photo 2 of 2 : UCIP_FA_2022_77383_102720.jpg

LM Start	9.75	Rating **	U	Issue No.	75 (cont)
LM End	9.75	Issue Type +	En	Location *	
Category	Supplemental		GPS Latitude/Longitude		
			Start	End	
Item	DWR UCIP Field Study		36.807777 °	36.807777 °	
			-120.168843 °	-120.168843 °	
DWR ID	19980

WS view: Closeup of slidegates from toe.

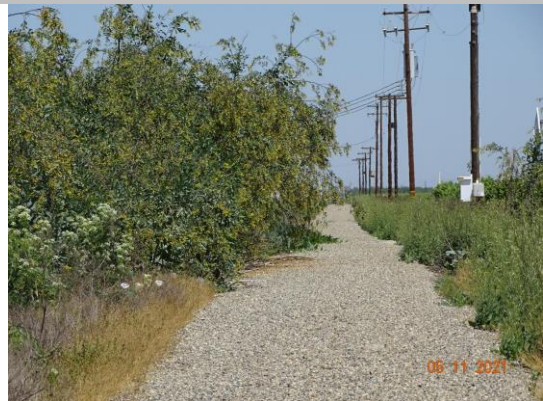
Photo 1 of 1 : FA_2022_NA0010_139_58_20220822_00012.jpg

LM Start	9.76	Rating **	M	Issue No.	58
LM End	9.81	Issue Type +	Ma	Location *	LS
Category	Earthen Levee			GPS Latitude/Longitude	
				Start	End
Item	Trim / Thin Trees			36.807810 °	36.808553 °
				-120.168829 °	-120.168827 °
DWR ID	DWR_NA0010_23_f_2018_58				
Comment Code					
T4 : Trim trees over roadway to at least 12 feet above ground level.					
Inspector Comment					
Woody vegetation is partially blocking crown and landside slope.

Woody vegetation on landside toe obstructing landside of crown. (Spring 2021)

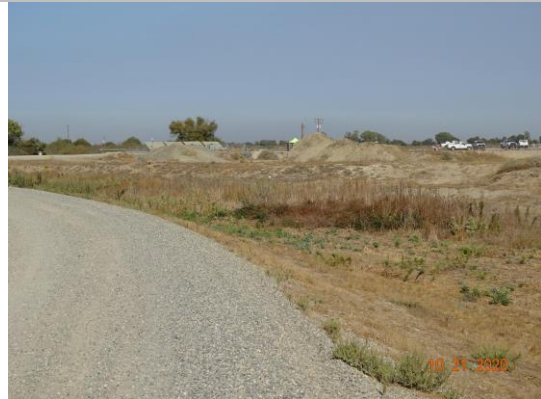
Photo 1 of 1 : FA_2022_NA0010_140_47_20220822_00013.jpg

LM Start	0.06	Rating **	M	Issue No.	47
LM End	0.06	Issue Type +	En	Location *	WS
Category	Earthen Levee			GPS Latitude/Longitude	
				Start	End
Item	Encroachments			36.772328 °	36.772328 °
				-120.285117 °	-120.285117 °
DWR ID	DWR_NA0010_24_s_2014_47				
Comment Code					
MA : Material					
Inspector Comment					
The District constructed a berm on waterside slope. The berm is being used for staging of earthen material.

Berm and material constructed off the waterside slope. (Fall 2020)

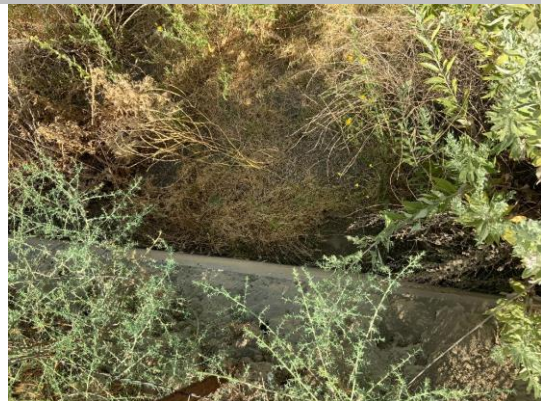
Photo 1 of 2 : UCIP_FA_2022_73629_102764.jpg

Comment Code						
Inspector Comment						
DS_ID:19955 FS_ID:73629 EP_NO: N/A Repair Type: Non-Urgent EVAL Issue: 11, Maintenance Compliance Issue Crossing Status: Found UCIP Comments: 07/20/2021 The record remains Non-Urgent. Cannot access LS inlet due to barbed wire, but appears to have sediment buildup. WS flapgate inaccessible due to steep hill and dense vegetation, recommend clearing vegetation and sediment out on both WS and LS inlet/outlet. No permit was found authorizing this encroachment. CVFPB will need to review crossing to determine owner. The UCIP inspection was completed with GEI staff, P. Espinoza. (H. Dunn – GEI)04/08/2014 No access available to confirm condition of landward side headwall. Recommend clearing debris along fence. Surface erosion near concrete headwall on landward side was present. (O. Magana - DWR UCIP) FIELD_STRUCT_DESC: 30-inch by 30-inch square reinforced concrete box gravity drainage culvert (RCBC) through the levee, 13.5 feet below the crown. Flap gate on the waterside (WS) end. Concrete headwall on each end. [Additional Reference(s): DWR Levee Log, 2002, (HLM 0.49)]. FS Date: 7/20/2021

LS view: Top of headwall at toe.

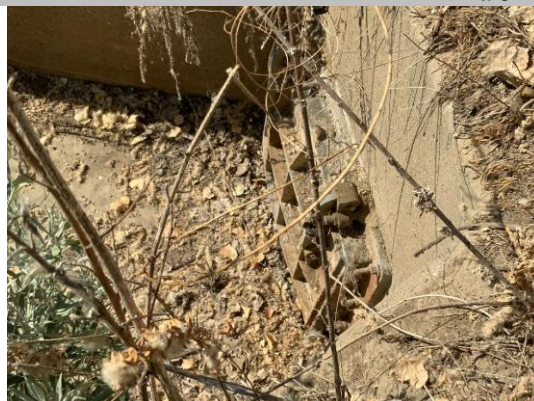
Photo 2 of 2 : UCIP_FA_2022_73629_102761.jpg

LM Start	0.50	Rating **	M	Issue No.	267 (cont)	
LM End	0.50	Issue Type +	En	Location *		
Category	Supplemental			GPS Latitude/Longitude		
				Start	End	
Item	DWR UCIP Field Study			36.766872 °	36.766872 °	
				-120.283212 °	-120.283212 °	
DWR ID	19955

WS view: Closeup of flapgate at toe.

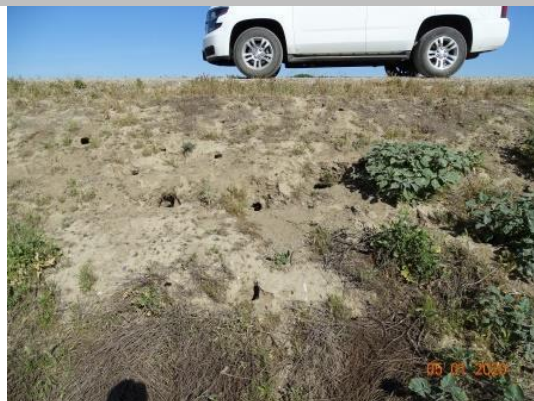
Photo 1 of 1 : FA_2022_NA0010_140_6_20220822_00001.jpg

LM Start	0.80	Rating **	M	Issue No.	6
LM End	0.84	Issue Type +	Ma	Location *	LS
Category	Earthen Levee			GPS Latitude/Longitude	
				Start	End
Item	Animal Control			36.766553 °	36.766962 °
				-120.278947 °	-120.278602 °
DWR ID	DWR_NA0010_24_s_2013_6				
Comment Code					
A1 : Exterminate rodents and backfill and compact or grout burrows.					
Inspector Comment					
There are several rodent holes identified within this section.

Rodent burrows in the landside slope. (Spring 2020)

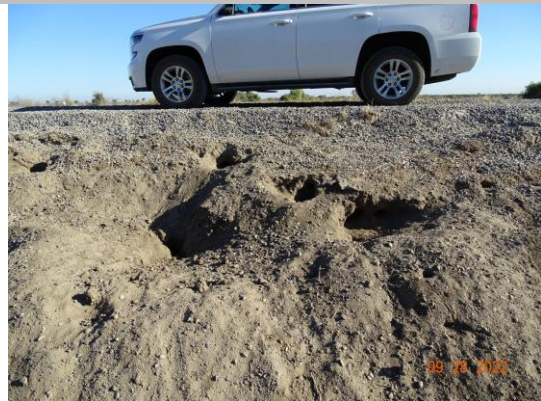
Photo 1 of 1 : FA_2022_NA0010_140_28_20221014_00016.jpg

LM Start	3.53	Rating **	U	Issue No.	28
LM End	3.59	Issue Type +	Ma	Location *	LS
Category	Earthen Levee			GPS Latitude/Longitude	
				Start	End
Item	Animal Control			36.768886 °	36.768531 °
				-120.237154 °	-120.236226 °
DWR ID	DWR_NA0010_24_f_2019_28				
Comment Code					
A3 : No rodents visible, but rodent burrows visible; need to backfill and compact or grout burrows.					
Inspector Comment

View of rodent burrows in the landside slope. (Fall 2022)

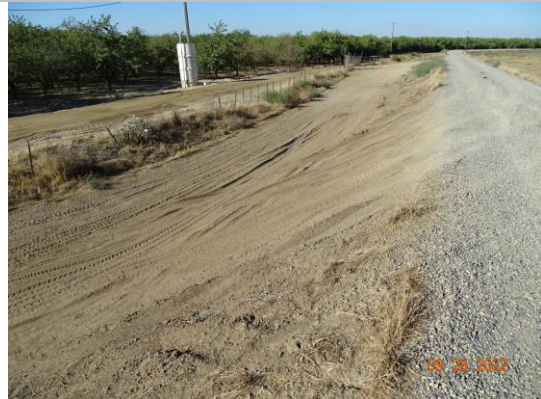
Photo 1 of 1 : FA_2022_NA0010_140_37_20221014_00017.jpg

LM Start	3.84	Rating **	A/W	Issue No.	37
LM End	3.84	Issue Type +	Ma	Location *	LS
Category	Earthen Levee			GPS Latitude/Longitude	
				Start	End
Item	Erosion / Vehicle Traffic			36.768024 °	36.768024 °
				-120.231896 °	-120.231896 °
DWR ID	DWR_NA0010_24_f_2022_37				
Comment Code					
E6 : Repair the levee slope damaged by vehicle traffic and prevent access where possible.					
Inspector Comment

Damage to the landside slope from vehicle traffic. (Fall 2022)

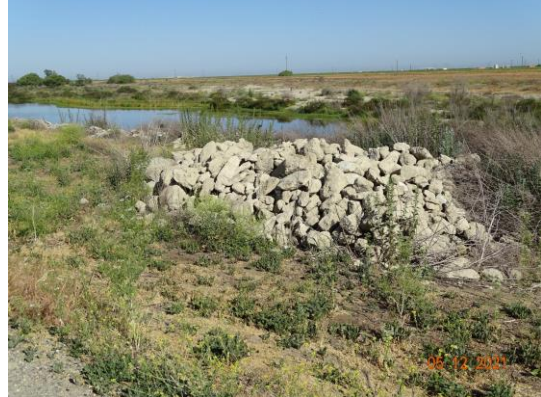
Photo 1 of 1 : FA_2022_NA0010_140_266_20220822_00015.jpg

LM Start	5.30	Rating **	M	Issue No.	266
LM End	5.30	Issue Type +	En	Location *	WS
Category	Earthen Levee			GPS Latitude/Longitude	
				Start	End
Item	Encroachments			36.781960 °	36.781960 °
				-120.224496 °	-120.224496 °
DWR ID	DWR_NA0010_24_s_2015_266				
Comment Code					
MA : Material					
Inspector Comment					
Rocks are stockpiled near the waterside toe.

Stockpile of rock kept in the river channel. (Spring 2021)

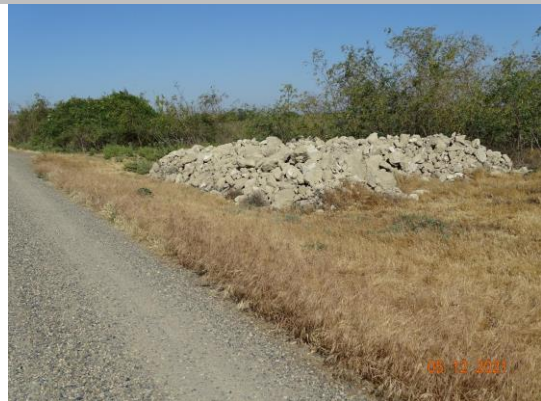
Photo 1 of 1 : FA_2022_NA0010_140_25_20220822_00010.jpg

LM Start	5.40	Rating **	M	Issue No.	25
LM End	5.40	Issue Type +	En	Location *	WS
Category	Earthen Levee			GPS Latitude/Longitude	
				Start	End
Item	Encroachments			36.782397 °	36.782397 °
				-120.222815 °	-120.222815 °
DWR ID	DWR_NA0010_24_s_2021_25				
Comment Code					
MA : Material					
Inspector Comment					
Rocks are stockpiled near the waterside toe.

Stockpile of rock kept at the waterside toe and river channel. (Spring 2021)

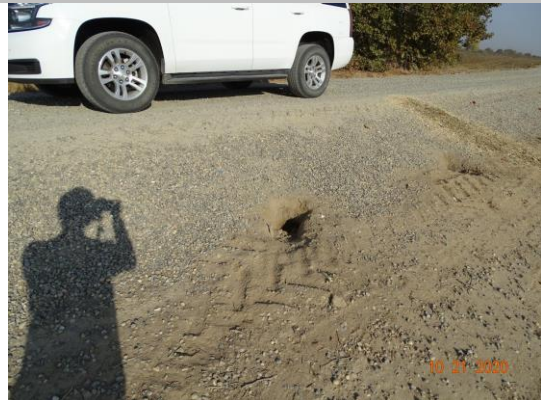
Photo 1 of 1 : FA_2022_NA0010_140_20_20220822_00008.jpg

LM Start	5.66	Rating **	M	Issue No.	20
LM End	5.66	Issue Type +	Ma	Location *	LS
Category	Earthen Levee			GPS Latitude/Longitude	
				Start	End
Item	Animal Control			36.784215 °	36.784215 °
				-120.218882 °	-120.218882 °
DWR ID	DWR_NA0010_24_f_2020_20				
Comment Code					
A3 : No rodents visible, but rodent burrows visible; need to backfill and compact or grout burrows.					
Inspector Comment

Rodent holes at the landside toe. (Fall 2020)

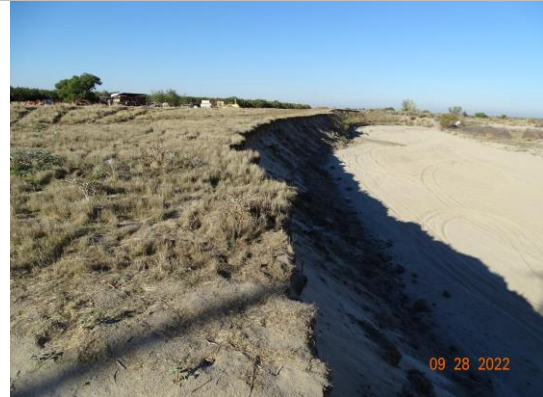
Photo 1 of 1 : FA_2022_NA0010_140_30_20221014_00018.jpg

LM Start	6.01	Rating **	A/W	Issue No.	30
LM End	6.08	Issue Type +	Ma	Location *	WS
Category	Earthen Levee			GPS Latitude/Longitude	
				Start	End
Item	Erosion / Bank Caving			36.787515 °	36.787815 °
				-120.215337 °	-120.214132 °
DWR ID	DWR_NA0010_24_f_2022_30				
Comment Code					
E1 : Note and monitor erosion site.					
Inspector Comment					
Erosion is approximately 20 feet from levee toe and has not yet eroded into the theoretical prism. Approximately 20 feet vertical erosion and 825 feet long. Recommend monitoring and measuring during high water.

View of erosion on the waterside berm. (Fall 2022)

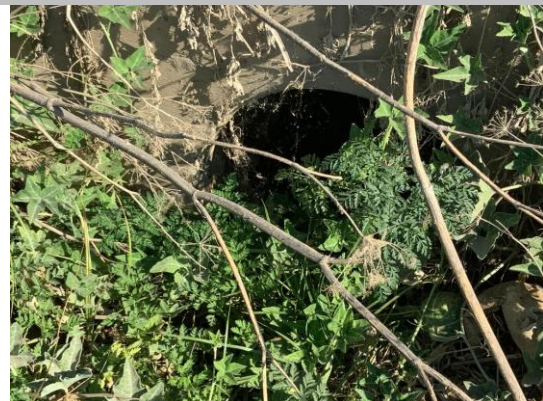
Photo 1 of 1 : UCIP_FA_2022_73634_102808.jpg

LM Start	6.09	Rating **	M	Issue No.	268
LM End	6.09	Issue Type +	En	Location *	
Category	Supplemental			GPS Latitude/Longitude	
				Start	End
Item	DWR UCIP Field Study			36.787864 °	36.787864 °
				-120.213912 °	-120.213912 °
DWR ID	19956

Comment Code					
Inspector Comment					
DS_ID:19956 FS_ID:73634 EP_NO: N/A Repair Type: Non-Urgent EVAL Issue: 11, Maintenance Compliance Issue Crossing Status: Found UCIP Comments: 07/20/2021 The record has been upgraded from No Action Needed to Non-Urgent. Limited inspection due to some vegetation covering LS pipe inlet, recommend removal. No permit was found authorizing this encroachment. CVFPB will need to review crossing to determine owner. Levee prism appears less than 3 feet in height. The UCIP inspection was completed with GEI staff, P. Espinoza. (H. Dunn – GEI) FIELD_STRUCT_DESC: 24-inch corrugated metal gravity drainage pipe (CMP) through the levee, 5.0 feet below the crown. Flap gate on the waterside (WS) end. Concrete headwall on the landside (LS) end. Concrete U-shaped headwall on the WS end. [Additional Reference(s): DWR Levee Log, 2002, (HLM 6.09)]. FS Date: 7/20/2021

LS view: Closeup of pipe inlet at toe covered by vegetation.

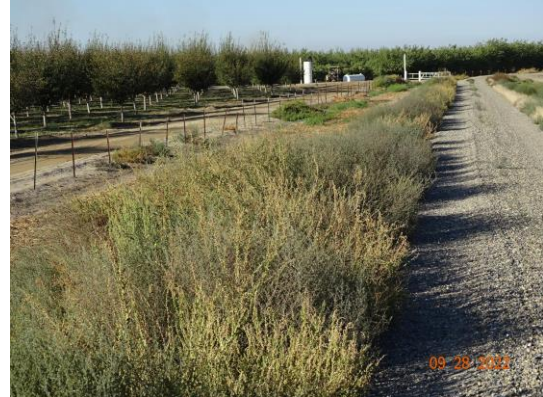
Photo 1 of 1 : FA_2022_NA0010_140_33_20221014_00019.jpg

LM Start	6.14	Rating **	U	Issue No.	33
LM End	6.87	Issue Type +	Ma	Location *	LS
Category	Earthen Levee			GPS Latitude/Longitude	
				Start	End
Item	Vegetation			36.788063 °	36.784563 °
				-120.213030 °	-120.203976 °
DWR ID	DWR_NA0010_24_f_2022_33				
Comment Code					
V1 : Control annual grass and weeds on the levee slopes and easements.					
Inspector Comment

View of landside slope looking downstream. (Fall 2022)
