Flood Control Project Maintenance Levee Inspections

Fall 2022 Levee Maintenance Deficiency Summary Report

San Joaquin River Basin

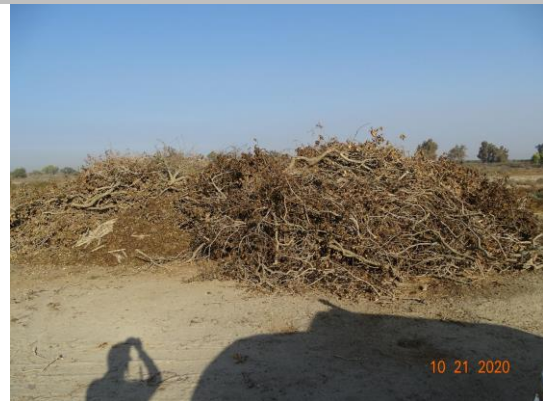
Photo 1 of 1 : FA_2022_NA0010_140_18_20220822_00006.jpg

LM Start	6.34	Rating **	U	Issue No.	18
LM End	6.34	Issue Type +	En	Location *	WS
Category	Earthen Levee			GPS Latitude/Longitude	
				Start	End
Item	Encroachments			36.788192 °	36.788192 °
				-120.209528 °	-120.209528 °
DWR ID	DWR_NA0010_24_f _ 2020_18				
Comment Code					
PR : Prunings					
Inspector Comment					
Prunings piled on the waterside berm.

Pruning pile left on the waterside toe. (Fall 2020)

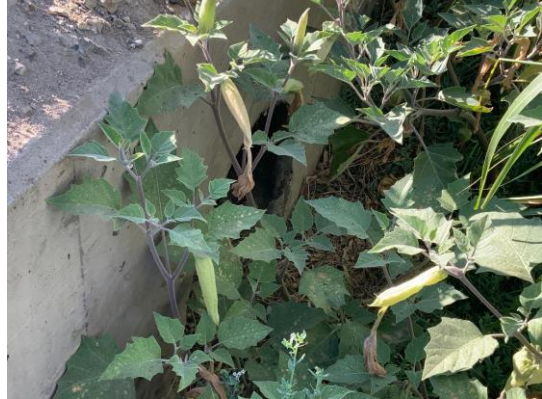
Photo 1 of 1 : UCIP_FA_2022_73635_102814.jpg

Comment Code					
Inspector Comment					
DS_ID:19957 FS_ID:73635 EP_NO: N/A Repair Type: Non-Urgent EVAL Issue: 11, Maintenance Compliance Issue Crossing Status: Found UCIP Comments: 07/20/2021 The record remains Non-Urgent. Limited inspection due to some vegetation covering LS pipe inlet, recommend removal. No permit was found authorizing this encroachment. CVFPB will need to review crossing to determine owner. The levee prism appears to be less than 3 feet. The UCIP inspection was completed with GEI staff, P. Espinoza. (H. Dunn – GEI) 7/20/2016 same as previous inspection. Crossing has been downgraded from Urgent to Non-Urgent PVC does not prevent WS flap gate from closing. (O. Magana - DWR UCIP)4/08/2014 Unauthorized PVC pipe through existitng crossing. PVC distorted inside--Need to contact owner to correct issue. If crossing was allowed need to contact owner for permit number issue for crossing variance. (O. Magana - DWR UCIP) FIELD_STRUCT_DESC: 24-inch corrugated metal gravity drainage pipe (CMP) through the levee, 3.6 feet below the crown. Flap gate on the waterside (WS) end. Concrete headwall on the landside (LS) end. Concrete U-shaped headwall on the WS end. [Additional Reference(s): DWR Levee Log, 2002, (HLM 6.72)]. FS Date: 7/20/2021

LS view: Closeup of pipe inlet at toe with vegetation overgrowth.

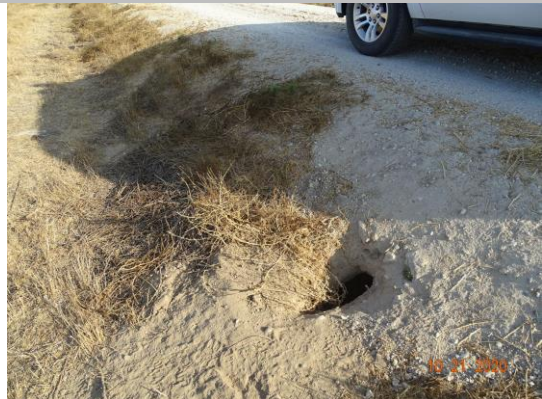
Photo 1 of 1 : FA_2022_NA0010_140_14_20220822_00005.jpg

LM Start	6.86	Rating **	M	Issue No.	14
LM End	6.86	Issue Type +	Ma	Location *	LS
Category	Earthen Levee			GPS Latitude/Longitude	
				Start	End
Item	Animal Control			36.784716 °	36.784716 °
				-120.204043 °	-120.204043 °
DWR ID	DWR_NA0010_24_f_2020_14				
Comment Code					
A3 : No rodents visible, but rodent burrows visible; need to backfill and compact or grout burrows.					
Inspector Comment

Rodent burrow on the landside slope. (Fall 2020)

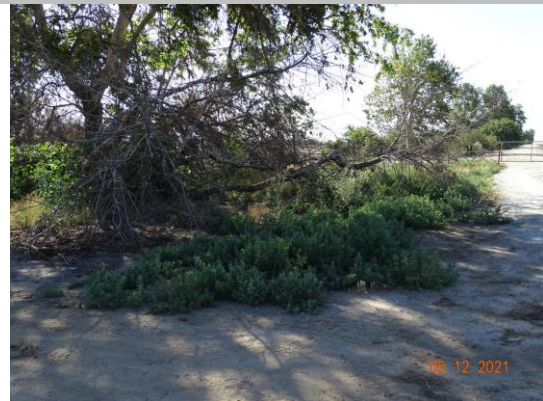
Photo 1 of 1 : FA_2022_NA0010_140_21_20220822_00009.jpg

LM Start	7.33	Rating **	M	Issue No.	21
LM End	7.33	Issue Type +	Ma	Location *	WS
Category	Earthen Levee			GPS Latitude/Longitude	
				Start	End
Item	Trim / Thin Trees			36.779416 °	36.779416 °
				-120.199091 °	-120.199091 °
DWR ID	DWR_NA0010_24_s_2021_21				
Comment Code					
T2 : Tree or limb.					
Inspector Comment

Tree limb fallen on the waterside slope. (Spring 2021)

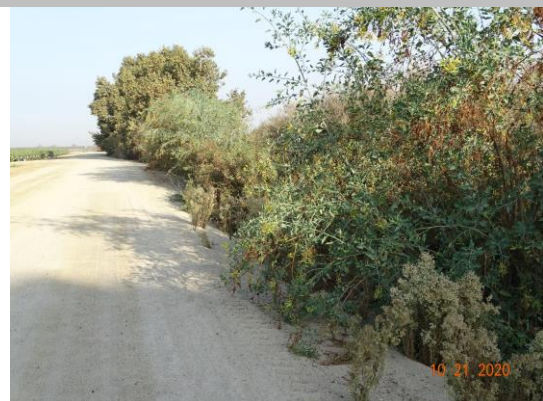
Photo 1 of 1 : FA_2022_NA0010_140_10_20220822_00003.jpg

LM Start	7.35	Rating **	U	Issue No.	10
LM End	7.76	Issue Type +	Ma	Location *	WS
Category	Earthen Levee			GPS Latitude/Longitude	
				Start	End
Item	Vegetation			36.779209 °	36.775267 °
				-120.198886 °	-120.193634 °
DWR ID	DWR_NA0010_24_f_2020_10				
Comment Code					
V2 : Remove the wild growth and woody vegetation other than native grasses from the levee slopes.					
Inspector Comment

View of the waterside slope looking downstream. (Fall 2020)

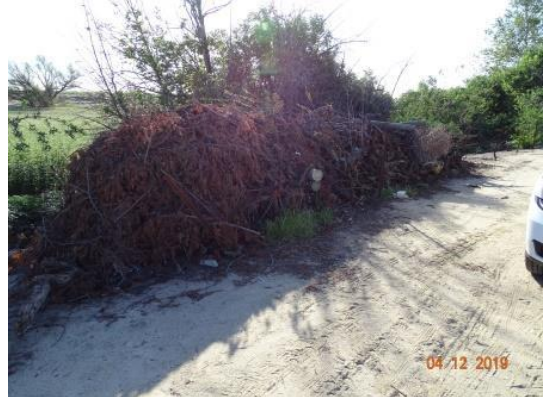
Photo 1 of 1 : FA_2022_NA0010_140_19_20220822_00007.jpg

LM Start	7.38	Rating **	M	Issue No.	19
LM End	7.38	Issue Type +	En	Location *	WS
Category	Earthen Levee			GPS Latitude/Longitude	
				Start	End
Item	Trim / Thin Trees			36.778838 °	36.778838 °
				-120.198478 °	-120.198478 °
DWR ID	DWR_NA0010_24_s_2019_19				
Comment Code					
T2 : Tree or limb.					
Inspector Comment

View of tree and prunings left on waterside shoulder. (Spring 2019)

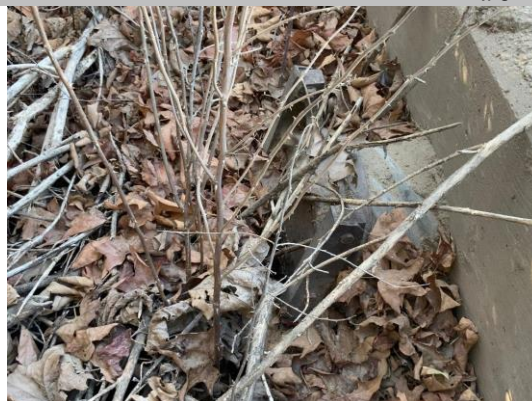
Photo 2 of 2 : UCIP_FA_2022_73636_102832.jpg

Comment Code					
Inspector Comment					
DS_ID:19958 FS_ID:73636 EP_NO: N/A Repair Type: Non-Urgent EVAL Issue: 11, Maintenance Compliance Issue Crossing Status: Found UCIP Comments: 07/20/2021 The record has been upgraded from No Action Needed to Non-Urgent. Limited inspection due to LS pipe inlet covered by sediment and WS flapgate covered by vegetation debris, recommend clearing out both sides. Levee prism appears to be less than 3 feet in height. No permit was found authorizing this encroachment. CVFPB will need to review crossing to determine owner. The UCIP inspection was completed with GEI staff, P. Espinoza. (H. Dunn – GEI) FIELD_STRUCT_DESC: 12-inch corrugated metal gravity drainage pipe (CMP) through the levee, 2.5 feet below the crown. Flap gate on the waterside (WS) end. Concrete headwall on each end. [Additional Reference(s): DWR Levee Log, 2002, (HLM 7.63)]. FS Date: 7/20/2021

WS view: Closeup of flapgate at toe with vegetation debris.

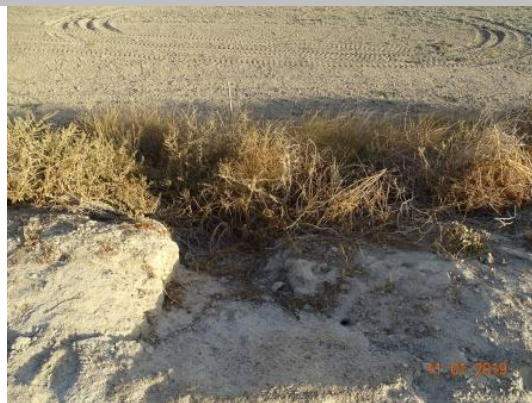
Photo 1 of 1 : FA_2022_NA0010_140_11_20220822_00004.jpg

LM Start	7.83	Rating **	A/W	Issue No.	11
LM End	7.83	Issue Type +	Ma	Location *	WS
Category	Earthen Levee			GPS Latitude/Longitude	
				Start	End
Item	Erosion / Bank Caving			36.775271 °	36.775271 °
				-120.192400 °	-120.192400 °
DWR ID	DWR_NA0010_24_f_2019_11				
Comment Code					
E1 : Note and monitor erosion site.					
Inspector Comment

Looking East down the waterside slope. (Fall 2019)

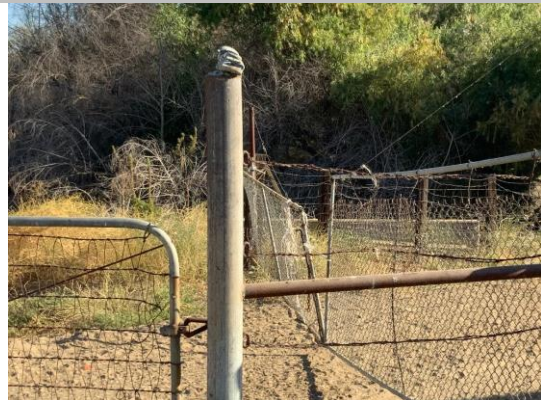
Comment Code						
Inspector Comment						
DS_ID:19959 FS_ID:73637 EP_NO: N/A Repair Type: Non-Urgent EVAL Issue: Crossing Status: Indicator Found UCIP Comments: 07/20/2021 The record is Non-Urgent. Possible WS headwall visible from the crown but inaccessible due to fences, limited inspection. Appears removed or abandoned due to no cobble outlet channel or outlet visible on the LS. LS end is completely flat and adjacent to a working farm. DWR DMP geophysical study did not confirm presence of pipe through levee. Record will remain in UCIP's inspection records until future Levee Improvement Project can confirm no crossing was found through the levee. No permit was found authorizing this encroachment. CVFPB will need to review crossing to determine owner. Levee prism appears to be less than 3 feet in height. The UCIP inspection was completed with GEI staff, P. Espinoza. (H. Dunn – GEI) FIELD_STRUCT_DESC: 36-inch reinforced concrete gravity drainage pipe (RCP) through the levee, 10.5 feet below the crown. Flap gate on the waterside (WS) end. Concrete headwall on the WS end. 10-foot cobble revetted outlet channel. [Additional Reference(s): DWR Levee Log, 2002, (HLM 8.16). USACE San Joaquin O&M Manual, Unit No. 601, Part No. 1, 1967, Amended in 1978, Revised 20 June 1985, (HLM 8.15). DWR As-Built Specification No. 65-30, Sheet No. 14, 27 April 1965, (HLM 8.15)]. FS Date: 7/20/2021

Levee crown.

LS view: Top of a headwall barely visible behind fences from crown.

WS view: Toe from crown, no pipe visible.

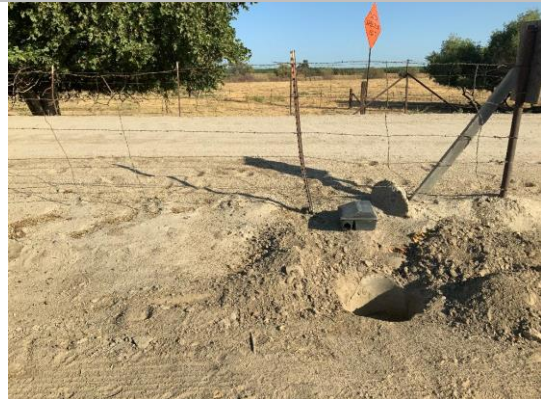
Photo 1 of 2 : UCIP_FA_2022_73638_102864.jpg

DS_ID:19960
 FS_ID:73638
 EP_NO: N/A
 Repair Type: Non-Urgent
 EVAL Issue: 11, Maintenance Compliance Issue
 Crossing Status: Found
 UCIP Comments: 07/20/2021 The record remains Non-Urgent. WS outlet filled with sediment, recommend cleaning out. LS pipe inlet not found, likely buried under dirt, recommend removal. No permit was found authorizing this encroachment. CVFPB will need to review crossing to determine owner. Levee prism appears to be less than 3 feet in height. The UCIP inspection was completed with GEI staff, P. Espinoza. (H. Dunn – GEI) 04/08/2014 Barbed wire along levee shoulder--no access. Need to confirm crossing size and condition of crossing. (O. Magana - DWR UCIP)
 FIELD_STRUCT_DESC: 12-inch reinforced concrete gravity drainage pipe (RCP) through the levee, 3.0 feet below the crown. Flap gate on the waterside (WS) end. Concrete headwall on the WS end. [Additional Reference(s): DWR Levee Log, 2002, (HLM 8.33). USACE San Joaquin O&M Manual, Unit No. 601, Part No. 1, 1967, Amended in 1978, Revised 20 June 1985, (HLM 8.32). DWR As-Built Specification No. 65-30, Sheet No. 14, 27 April 1965, (HLM 8.32)].

LS view: Slope from toe, no pipe visible.

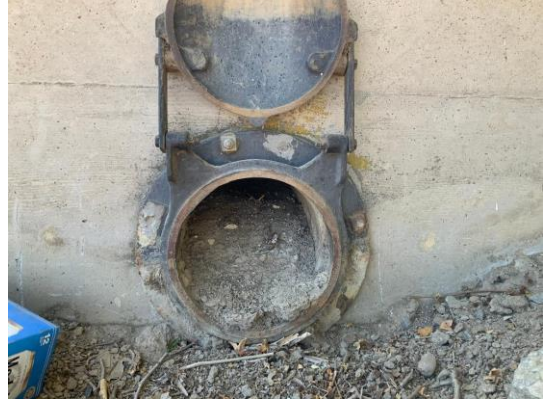
Photo 2 of 2 : UCIP_FA_2022_73638_102862.jpg

WS view: Closeup of flapgate and outlet filled with sediment at toe.

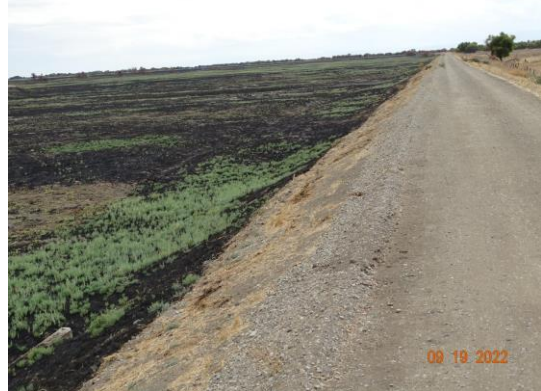
Photo 1 of 1 : FA_2022_NA0010_141_7_20221014_00002.jpg

LM Start	0.01	Rating **	A	Issue No.	7
LM End	0.01	Issue Type +	Ma	Location *	LS
Category	Earthen Levee			GPS Latitude/Longitude	
				Start	End
Item	Vegetation			37.296177 °	37.296177 °
				-120.880744 °	-120.880744 °
DWR ID	DWR_NA0010_25_f_2022_7				
Comment Code					
V1 : Control annual grass and weeds on the levee slopes and easements.					
Inspector Comment					
The annual vegetation is well maintained.

View of vegetation management on the landside slope. (Fall 2022)

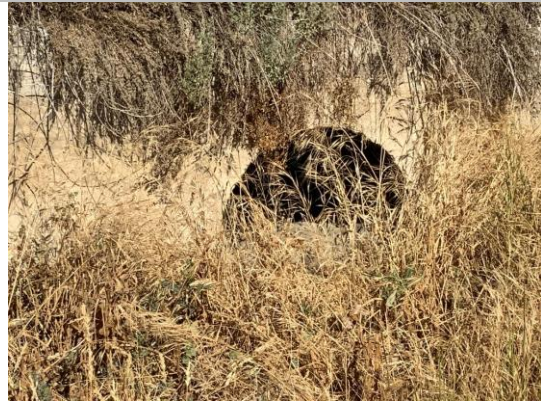
Photo 1 of 1 : UCIP_FA_2022_77386_100683.jpg

Comment Code						
Inspector Comment						
DS_ID:19965 FS_ID:77386 EP_NO: N/A Repair Type: Non-Urgent EVAL Issue: 11, Maintenance Compliance Issue Crossing Status: Found UCIP Comments: 06/8/2021 The record remains Non-Urgent. Landside (LS) pipe inlet has some vegetation and sediment buildup, recommend cleaning out. The UCIP inspection was completed with GEI staff, P. Espinoza. (H. Dunn – GEI) 05/01/2014 Dense vegetation limits the inspectors visibility to identify signs of pipe failure (leaks) along the slope. Recommend removing vegetation along pipe alignment to conduct proper inspection of structure. Sediment buildup in pipe visible from landward side--recommend clearing. (O. Magana - DWR UCIP) FIELD_STRUCT_DESC: 24-inch corrugated metal gravity drainage pipe (CMP) through the levee, 10.0 feet below the crown. Flap gate on the waterside (WS) end. Concrete headwalls on both ends. [Additional Reference(s): DWR Levee Log, 2002, (HLM 0.01). USACE San Joaquin O&M Manual, Unit No. 601, Part No. 1, 1967, Amended in 1978, Revised 20 June 1985, (HLM 0.02). DWR As-Built Specification No. 59-01, Sheet No. 49, 10 December 1958, (HLM 0.02)]. FS Date: 6/8/2021

LS view: Close up of pipe inlet at toe.

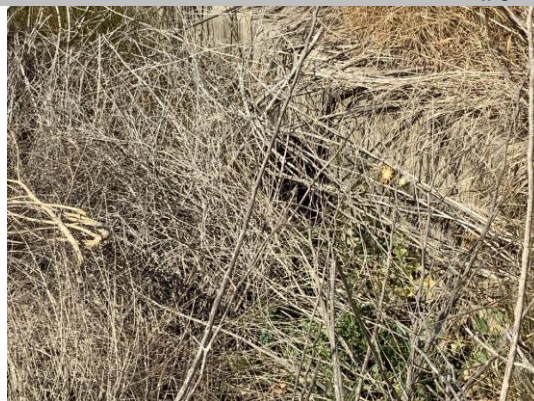
Photo 1 of 1 : UCIP_FA_2022_77387_100701.jpg

Comment Code						
Inspector Comment						
DS_ID:19966 FS_ID:77387 EP_NO: N/A Repair Type: Non-Urgent EVAL Issue: 11, Maintenance Compliance Issue Crossing Status: Found UCIP Comments: 06/8/2021 The record remains Non-Urgent. Dense LS vegetation over pipe inlet and headwall, recommend removal. The UCIP inspection was completed with GEI staff, P. Espinoza. (H. Dunn – GEI) 05/01/2014 Dense vegetation limits the inspectors visibility to identify signs of pipe failure (leaks) along the slope. Recommend removing vegetation along pipe alignment to conduct proper inspection of structure. (O. Magana - DWR UCIP) FIELD_STRUCT_DESC: 24-inch corrugated metal gravity drainage pipe (CMP) through the levee, 11.6 feet below the crown. Flap gate on the waterside (WS) end. Concrete headwalls on both ends. [Additional Reference(s): DWR Levee Log, 2002, (HLM 0.36). USACE San Joaquin O&M Manual, Unit No. 601, Part No. 1, 1967, Amended in 1978, Revised 20 June 1985, (HLM 0.35). DWR As-Built Specification No. 59-01, Sheet No. 49, 10 December 1958, (HLM 0.35)]. FS Date: 6/8/2021

LS view: Headwall barely visible at toe due to dense vegetation.

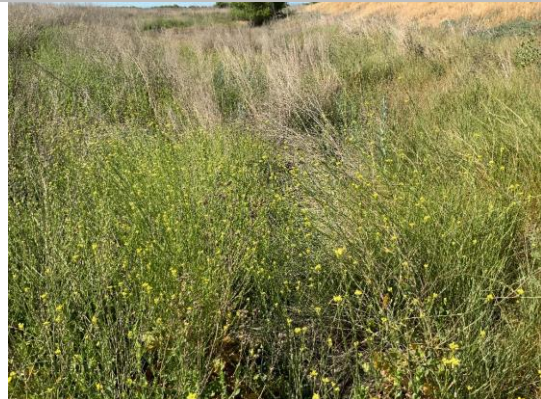
Photo 1 of 1 : UCIP_FA_2022_77388_100704.jpg

Comment Code					
Inspector Comment					
DS_ID:19967 FS_ID:77388 EP_NO: N/A Repair Type: Non-Urgent EVAL Issue: 11, Maintenance Compliance Issue Crossing Status: Found UCIP Comments: 06/8/2021 The record remains Non-Urgent. Dense LS vegetation, recommend removal around pipe inlet. The UCIP inspection was completed with GEI staff, P. Espinoza. (H. Dunn – GEI) 05/01/2014 Dense vegetation limits the inspectors visibility to identify signs of pipe failure (leaks) along the slope. Recommend removing vegetation along pipe alignment to conduct proper inspection of structure. (O. Magana - DWR UCIP) FIELD_STRUCT_DESC: 24-inch corrugated metal gravity drainage pipe (CMP) through the levee, 14.7 feet below the crown. Flap gate on the waterside (WS) end. Concrete headwalls on both ends. [Additional Reference(s): DWR Levee Log, 2002, (HLM 0.58). USACE San Joaquin O&M Manual, Unit No. 601, Part No. 1, 1967, Amended in 1978, Revised 20 June 1985, (HLM 0.58). DWR As-Built Specification No. 59-01, Sheet No. 49, 10 December 1958, (HLM 0.58)]. FS Date: 6/8/2021

LS view: Headwall and inlet covered by dense vegetation at toe.

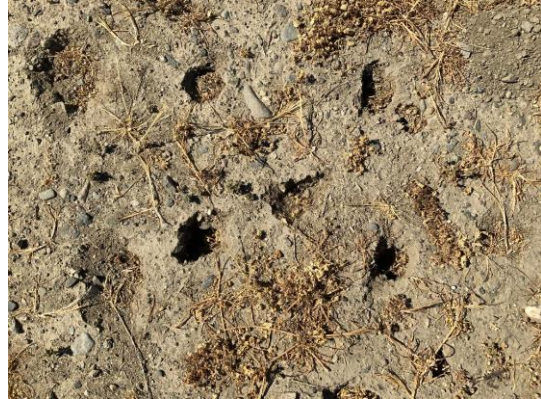
Photo 1 of 2 : UCIP_FA_2022_77389_100718.jpg

Crown: Small burrow holes along the crown, 1 of 2 photos.

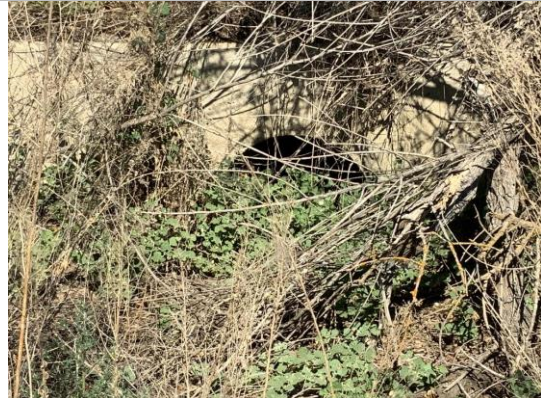
Photo 2 of 2 : UCIP_FA_2022_77389_100714.jpg

DS_ID:19968
FS_ID:77389
EP_NO: N/A
Repair Type: Non-Urgent
EVAL Issue: 11, Maintenance Compliance Issue
Crossing Status: Found
UCIP Comments: 06/8/2021 The record remains Non-Urgent. Dense LS vegetation over pipe inlet, recommend removal. Lots of small burrow holes all along the crown and along the sides, recommend filling in. The UCIP inspection was completed with GEI staff, P. Espinoza. (H. Dunn – GEI) 05/01/2014 Dense vegetation limits the inspectors visibility to identify signs of pipe failure (leaks) along the slope. Recommend removing vegetation along pipe alignment to conduct proper inspection of structure. (O. Magana - DWR UCIP)
FIELD_STRUCT_DESC: 24-inch corrugated metal gravity drainage pipe (CMP) through the levee, 11.4 feet below the crown. Flap gate on the waterside (WS) end. Concrete headwalls on both ends. [Additional Reference(s): DWR Levee Log, 2002, (HLM 0.97). USACE San Joaquin O&M Manual, Unit No. 601, Part No. 1, 1967, Amended in 1978, Revised 20 June 1985, (HLM 0.97). DWR As-Built Specification No. 59-01, Sheet No. 49, 10 December 1958, (HLM 0.97)].

LS view: Close up of pipe inlet covered with vegetation.

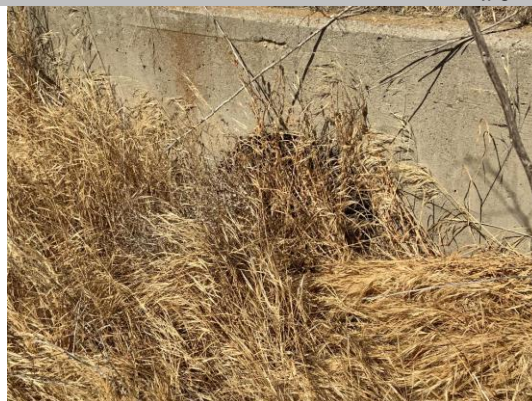
Photo 1 of 1 : UCIP_FA_2022_77390_100732.jpg

Comment Code						
Inspector Comment						
DS_ID:19969 FS_ID:77390 EP_NO: N/A Repair Type: Non-Urgent EVAL Issue: 11, Maintenance Compliance Issue Crossing Status: Found UCIP Comments: 06/8/2021 The record remains Non-Urgent. Levee prism appears to be around or slightly less than 3 feet. Dense vegetation on LS pipe inlet, recommend removal. The UCIP inspection was completed with GEI staff, P. Espinoza. (H. Dunn – GEI) 05/01/2014 Dense vegetation limits the inspectors visibility to identify signs of pipe failure (leaks) along the slope. Recommend removing vegetation along pipe alignment to conduct proper inspection of structure. (O. Magana - DWR UCIP) FIELD_STRUCT_DESC: 24-inch corrugated metal gravity drainage pipe (CMP) through the levee, 4.0 feet below the crown. Flap gate on the waterside (WS) end. Concrete headwalls on both ends. [Additional Reference(s): DWR Levee Log, 2002, (HLM 2.05). USACE San Joaquin O&M Manual, Unit No. 601, Part No. 1, 1967, Amended in 1978, Revised 20 June 1985, (HLM 2.05). DWR As-Built Specification No. 59-01, Sheet No. 50, 10 December 1958, (HLM 2.05)]. FS Date: 6/8/2021

LS view: Close up of pipe inlet at toe covered with vegetation.

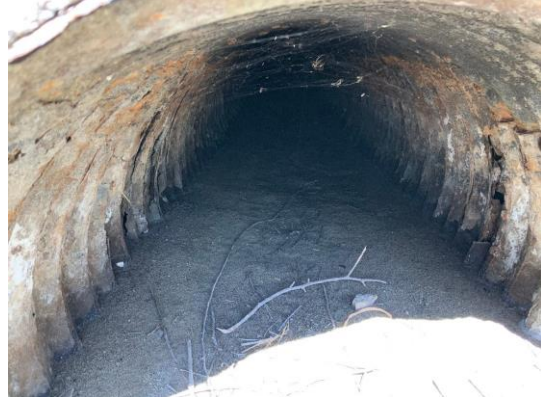
Photo 1 of 3 : UCIP_FA_2022_77391_100738.jpg

Comment Code						
Inspector Comment						
DS_ID:19970 FS_ID:77391 EP_NO: N/A Repair Type: Urgent EVAL Issue: 1, Pipe Integrity Crossing Status: Found UCIP Comments: 06/8/2021 Record has been upgraded from Non-Urgent to Urgent. External inspection in the field has found pipe integrity issues. WS pipe end is rusted with multiple large deteriorated holes under and around the flapgate. Rusting and peeling of metal and liner inside the LS pipe inlet. Also sediment buildup inside LS inlet, recommend cleaning out and recommend monitoring crossing until funding becomes available to address the issues. The UCIP inspection was completed with GEI staff, P. Espinoza. (H. Dunn – GEI)05/01/2014 Dense vegetation limits the inspectors visibility to identify signs of pipe failure (leaks) along the slope. Recommend removing vegetation along pipe alignment to conduct proper inspection of structure. Sediment buildup in pipe visible on landward side--recommend clearing. (O. Magana - DWR UCIP) FIELD_STRUCT_DESC: 24-inch corrugated metal gravity drainage pipe (CMP) through the levee, 11.2 feet below the crown. Flap gate on the waterside (WS) end. Concrete headwalls on both ends. [Additional Reference(s): DWR Levee Log, 2002, (HLM 2.45). USACE San Joaquin O&M Manual, Unit No. 601, Part No. 1, 1967, Amended in 1978, Revised 20 June 1985, (HLM 2.45). DWR As-Built Specification No. 59-01, Sheet No. 50, 10 December 1958, (HLM 2.45)]. FS Date: 6/8/2021

LS view: Inside of pipe inlet. Sediment buildup and rusted and peeling walls.

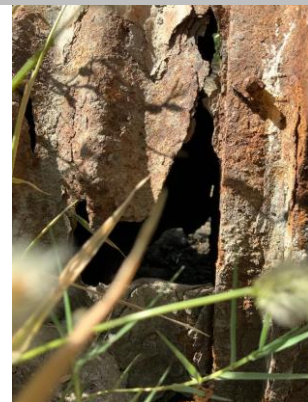
Photo 2 of 3 : UCIP_FA_2022_77391_100740.jpg

WS view: Deterioration of flapgate, 1 of 4 photos.

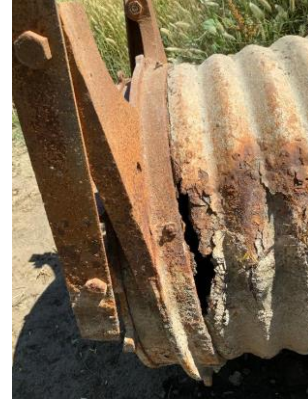
Photo 3 of 3 : UCIP_FA_2022_77391_100743.jpg

WS view: Deterioration of pipe, 2 of 4 photos.
