Flood Control Project Maintenance Levee Inspections

Fall 2024 Levee Maintenance Deficiency Summary Report

San Joaquin River Basin

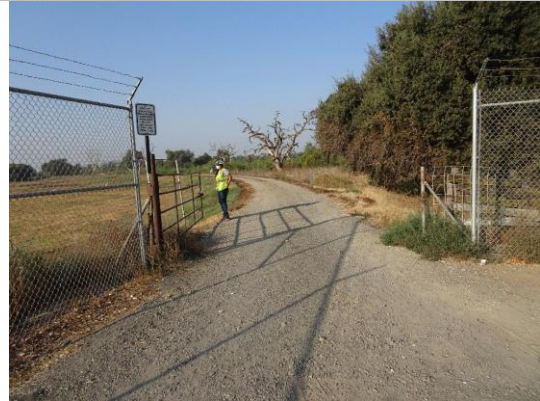
Photo 1 of 3 : UCIP_FA_2024_70636_92086.jpg

Comment Code						
Inspector Comment						
DS_ID:19650 FS_ID:70636 EP_NO: N/A Repair Type: No Action Needed EVAL Issue: Crossing Status: Found UCIP Comments: 09/18/2023 Record updated from Non-Urgent to No Action Needed. Pipe was CIPP lined. DMP internal video inspection has found none or minor pipe defects. Recommend next video inspection in 5 years. (O. Yakimov - DWR UCIP) 10/06/2020 Record remains Non-Urgent. DWR DMP has found integrity issues, LOF between 4 and 5. This crossing will be monitored until funding becomes available for rehabilitation. Dense vegetation was found along the LS and WS. No permit was found authorizing this encroachment. The CVFPB will need to review crossing to determine owner. (O. Magana - DWR UCIP, B. Singh - GEOM) 04/08/2014 Dense vegetation limits the inspector's visibility to identify signs of pipe failure (leaks) along the waterward slope and landward toe. Recommend removing vegetation along pipe alignment and landward toe to conduct proper inspection of structure and appurtenances. (W. Wylie - DWR UCIP) FIELD_STRUCT_DESC: 24-inch CIPP-lined corrugated metal (CM) gravity drainage pipe through the levee, 10.5 feet below the crown. Flap gate on the waterside (WS) end. Brass cap No. 108 bench mark (BM) on the headwall on the landside (LS), elevation 65.1 feet, USGS Datum. [Additional Reference(s): DWR Levee Log, 2002, (HLM 0.00). USACE San Joaquin O&M Manual, Unit No. 601, Part No. 1, (SJR601.1), 1967, Revised 25 May 2011, (HLM 0.02)]. FS Date: 10/6/2020

Overview of levee crown looking upstream towards pipe crossing. Pipe is located near gate entrance.

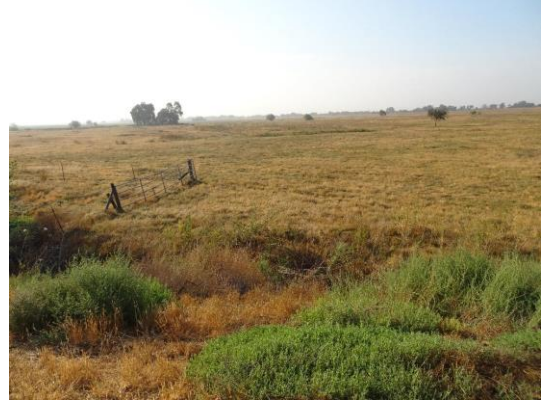
Photo 2 of 3 : UCIP_FA_2024_70636_92088.jpg

LS view: overview of LS, dense vegetation on slope and levee toe.

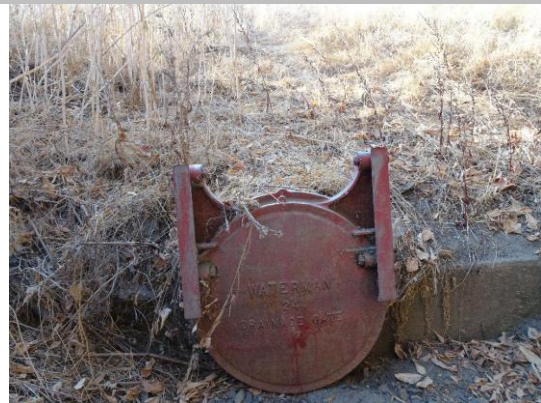
Photo 3 of 3 : UCIP_FA_2024_70636_92089.jpg

WS view: gate visible on the WS toe with concrete concrete wall supporting pipe.

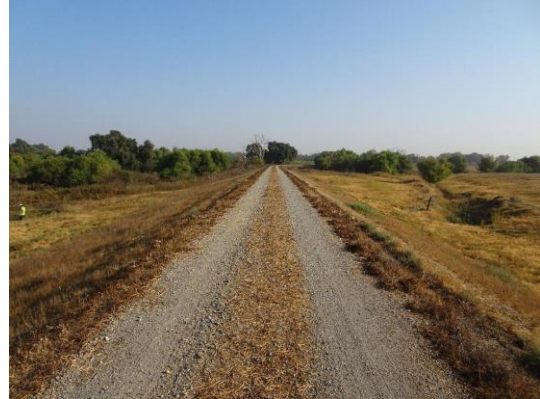
Photo 1 of 3 : UCIP_FA_2024_70637_90529.jpg

Comment Code					
Inspector Comment					
DS_ID:19651 FS_ID:70637 EP_NO: N/A Repair Type: Non-Urgent EVAL Issue: 11, Maintenance Compliance Issue Crossing Status: Found UCIP Comments: 10/06/2020 Record remains Non-Urgent. No permit was found authorizing this encroachment. Sediment buildup found on the LS. Recommend maintenance to clear up sediment buildup along pipe invert. CVFPB will need to review crossing to determine owner. DWR DMP internal inspection is pending and scheduled for 2021. (O. Magana - DWR UCIP, B. Singh - GE04/08/2014 Pipe has significant sediment buildup and shows some signs of corrosion at landward toe. Recommend cleaning sediment from inside pipe and check wall integrity. (W. Wylie - DWR UCIP) FIELD_STRUCT_DESC: 36-inch corrugated metal (CM) gravity drainage pipe through the levee, 18.5 feet below the crown. Flap gate on the waterside (WS) end. Brass cap No. 108 bench mark (BM) on the headwall on the landside (LS). [Additional Reference(s): DWR Levee Log, 2002, (HLM 0.35). USACE San Joaquin O&M Manual, Unit No. 601, Part No. 1, (SJR601.1), 1967, Revised 25 May 2011, (HLM 0.35)]. FS Date: 10/6/2020

Overview of levee looking US

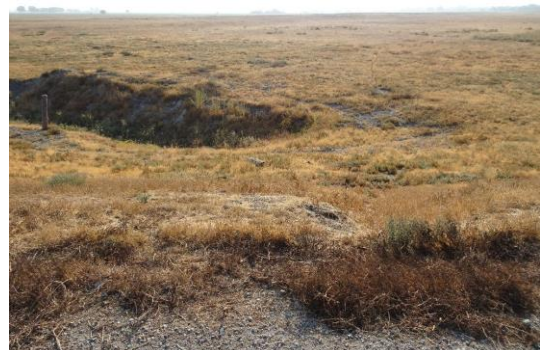
Photo 2 of 3 : UCIP_FA_2024_70637_90530.jpg

LS view: Overview of LS from levee crest, looking US

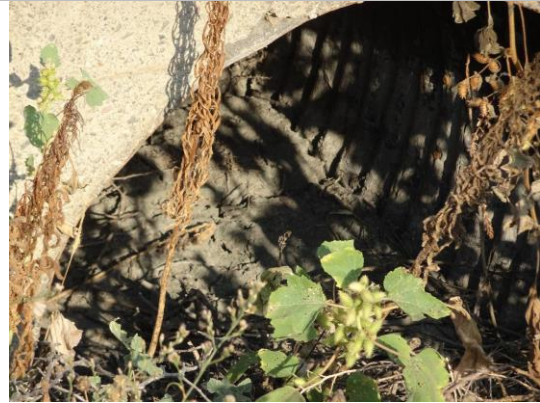
Photo 3 of 3 : UCIP_FA_2024_70637_92300.jpg

LS view: sediment build up along the pipe invert.

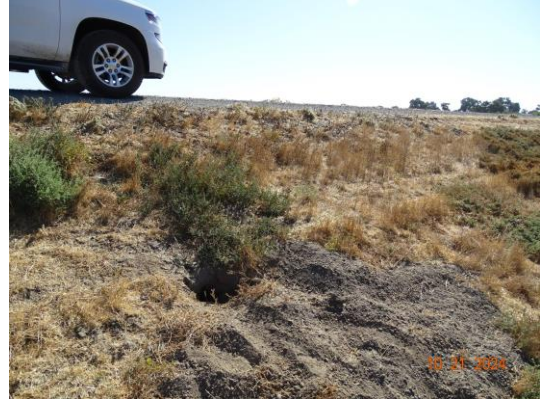
Photo 1 of 1 : FA_2024_NA0010_118_89_20241105_00252.jpg

LM Start	0.54	Rating **	M	Issue No.	89
LM End	0.54	Issue Type +	Ma	Location *	WS
Category	Earthen Levee			GPS Latitude/Longitude	
				Start	End
Item	Animal Control			37.342385 °	37.342385 °
				-120.961039 °	-120.961039 °
DWR ID	DWR_NA0010_01_f_2024_89				
Comment Code					
A3 : No rodents visible, but rodent burrows visible; need to backfill and compact or grout burrows.					
Inspector Comment

View of rodent burrows on the waterside slope. (Fall 2024)

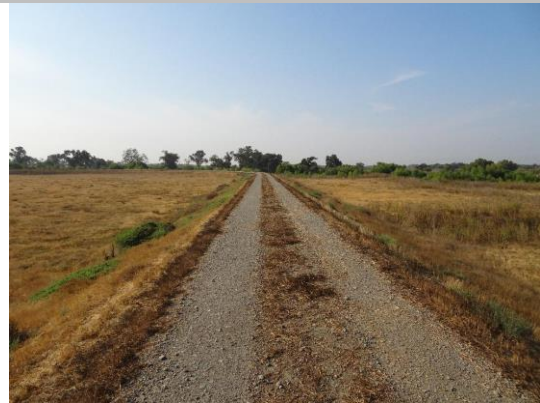
Photo 1 of 3 : UCIP_FA_2024_85057_90537.jpg

Comment Code						
Inspector Comment						
DS_ID:19583 FS_ID:85057 EP_NO: N/A Repair Type: No Action Needed EVAL Issue: Crossing Status: Found UCIP Comments: 04/23/2024 Record updated from Non-Urgent to No Action Needed. DMP internal video inspection has found none or minor pipe defects. (M. Thao - DWR UCIP) 10/06/2020 Record remains Non-Urgent. No permit was found authorizing this encroachment. Rodent activity found near pipe location. CVFPB will need to review crossing to determine owner. DWR DMP has not found internal issues, LOF between 1 and 2. Recommend inspection in 5 years. (B. Singh - GEI, O. Magana - DWR UCIP) 04/08/2014 Recommend removing vegetation pile from waterward toe. (W. Wylie - DWR UCIP) FIELD_STRUCT_DESC: 24-inch corrugated metal (CM) gravity drainage pipe through the levee, 8.5 feet below the crown. Flap gate on the waterside (WS) end. Brass cap No. 108 bench mark (BM) on the headwall on the landside (LS). [Additional Reference(s): DWR Levee Log, 2002, (HLM 0.62). USACE San Joaquin O&M Manual, Unit No. 601, Part No. 1, (SJR601.1), 1967, Revised 25 May 2011, (HLM 0.62)]. FS Date: 10/6/2020

Overview of levee crown, looking US

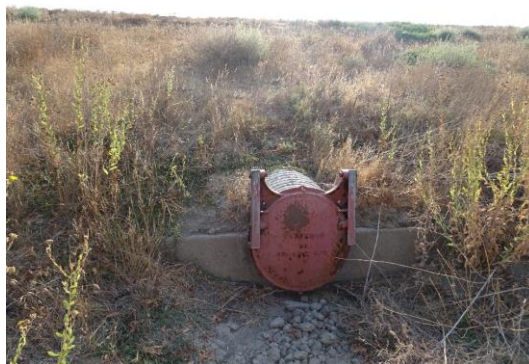
Photo 2 of 3 : UCIP_FA_2024_85057_90535.jpg

WS view: Flapgate and headwall at WS toe

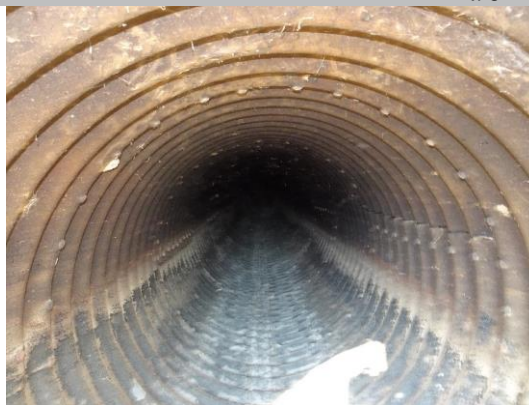
Photo 3 of 3 : UCIP_FA_2024_85057_90540.jpg

LS view: Inside pipe from LS toe

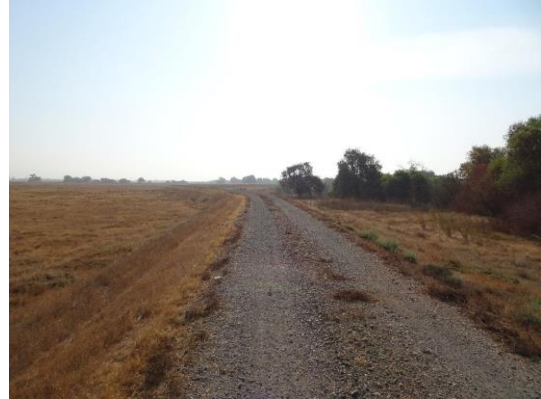
Photo 1 of 3 : UCIP_FA_2024_70639_90541.jpg

Comment Code					
Inspector Comment					
DS_ID:19584 FS_ID:70639 EP_NO: N/A Repair Type: Non-Urgent EVAL Issue: Crossing Status: Found UCIP Comments: 10/06/2020 Record has been updated from No Action Needed to Non-Urgent. No permit was found authorizing this encroachment. CVFPB will need to review crossing to determine owner. Rodent activity found near this stretch of levee. DWR DMP has not found internal issues, LOF between 1 and 2. Recommend inspection in 5 years. (B. Singh - GEI, O. Magana - DWR UCIP) FIELD_STRUCT_DESC: 24-inch corrugated metal (CM) gravity drainage pipe through the levee, 7.0 feet below the crown. Flap gate on the waterside (WS) end. Brass cap No. 108 bench mark (BM) on the headwall on the landside (LS). [Additional Reference(s): DWR Levee Log, 2002, (HLM 0.88). USACE San Joaquin O&M Manual, Unit No. 601, Part No. 1, (SJR601.1), 1967, Revised 25 May 2011, (HLM 0.87)]. FS Date: 10/6/2020

Overview of levee crown, looking US

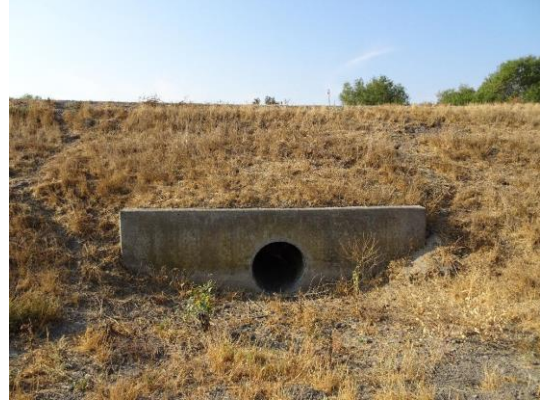
Photo 3 of 3 : UCIP_FA_2024_70639_90544.jpg

LS view: Pipe and headwall at LS toe

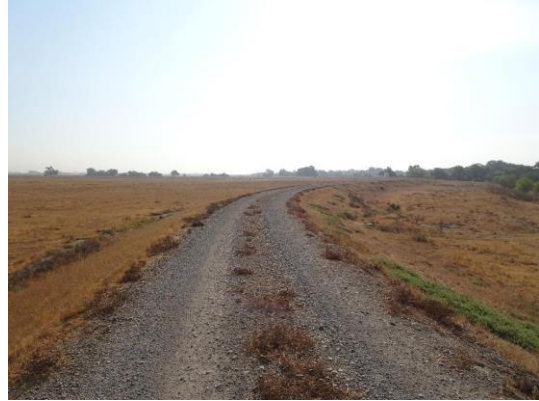
Photo 2 of 3 : UCIP_FA_2024_83233_90550.jpg

Comment Code						
Inspector Comment						
DS_ID:19585 FS_ID:83233 EP_NO: N/A Repair Type: No Action Needed EVAL Issue: Crossing Status: Found UCIP Comments: 04/23/2024 Record updated from Urgent to No Action Needed. The scour noted from previous inspection behind the concrete headwall on the LS toe has been corrected by the LMA. DMP internal video inspection has found none or minor pipe defects. (M. Thao - DWR UCIP) 12/19/2022 Record remains Urgent. Pipe has been CIPP-lined. LOF of crossing is less or equal to 4. Recommend next video inspection in 5 years. Scour behind the concrete headwall on the LS toe needs repair. (O. Yakimov - DWR UCIP) 10/06/2020 Record has been updated from Non-Urgent to Urgent. DWR DMP has found integrity issues, LOF between 5 and 6. Scour visible behind the concrete headwall on the LS toe. Recommend monitoring crossing until funding becomes available to addressed. No permit was found authorizing this encroachment. CVFPB will need to review crossing to determine owner. (B. Singh - GEI, O. Magana - DWR UCIP) 04/08/2014 Moderate erosion around headwall on landward toe. May or may not be an issue. Need to contact owner to determine status of crossing and to address erosion issue on landward side. (W. Wylie - DWR UCIP) FIELD_STRUCT_DESC: 24-inch CIPP-lined corrugated metal (CM) gravity drainage pipe through the levee, 9.0 feet below the crown. Flap gate on the waterside (WS) end. Brass cap No. 108 bench mark (BM) on the headwall on the landside (LS). [Additional Reference(s): DWR Levee Log, 2002, (HLM 0.96). USACE San Joaquin O&M Manual, Unit No. 601, Part No. 1, (SJR601.1), 1967, Revised 25 May 2011, (HLM 0.95)]. FS Date: 10/6/2020 4:21:36 PM

Overview of levee crown, looking US

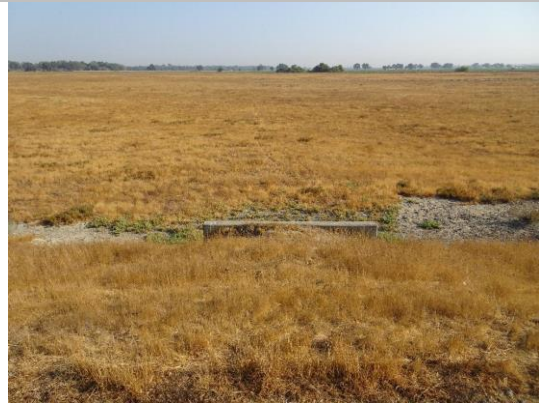
Photo 3 of 3 : UCIP_FA_2024_83233_90552.jpg

LS view: Headwall visible on LS toe

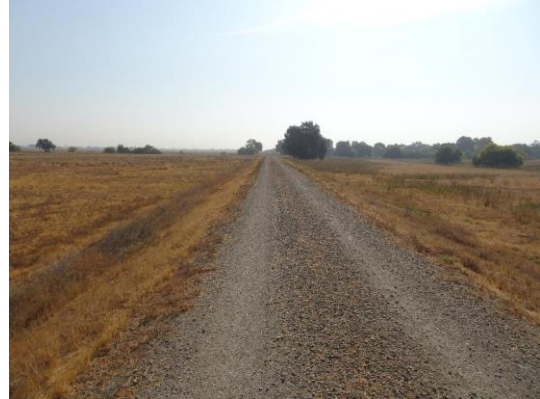
Photo 1 of 3 : UCIP_FA_2024_83235_90554.jpg

Comment Code						
Inspector Comment						
DS_ID:19586 FS_ID:83235 EP_NO: N/A Repair Type: No Action Needed EVAL Issue: Crossing Status: Found UCIP Comments: 04/23/2024 Record updated from Non-Urgent to No Action Needed. DMP internal video inspection has found none or minor pipe defects. (M. Thao - DWR UCIP) 10/06/2020 Record has been updated from No Action Needed to Non-Urgent. No permit was found authorizing this encroachment. CVFPB will need to review crossing to determine owner. DWR DMP has not found internal issues, LOF between 1 and 2. Recommend inspection in 5 years. (B. Singh - GEI, O. Magana - DWR UCIP) FIELD_STRUCT_DESC: 24-inch corrugated metal (CM) gravity drainage pipe through the levee, 7.5 feet below the crown. Flap gate on the waterside (WS) end. Brass cap No. 108 bench mark (BM) on the headwall on the landside (LS). [Additional Reference(s): DWR Levee Log, 2002, (HLM 1.18). USACE San Joaquin O&M Manual, Unit No. 601, Part No. 1, (SJR601.1), 1967, Revised 25 May 2011, (HLM 1.17)]. FS Date: 10/6/2020

Overview of levee crown, looking US

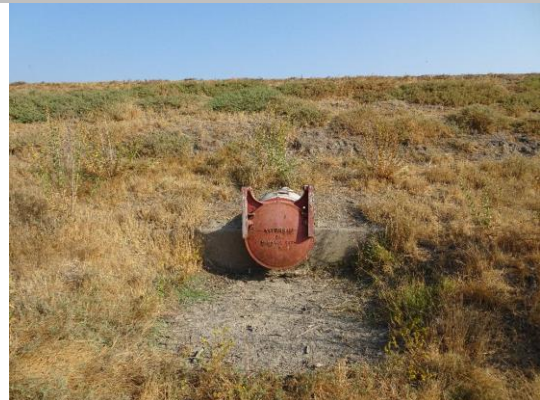
Photo 2 of 3 : UCIP_FA_2024_83235_90553.jpg

Pipe, flapgate and headwall on WS toe

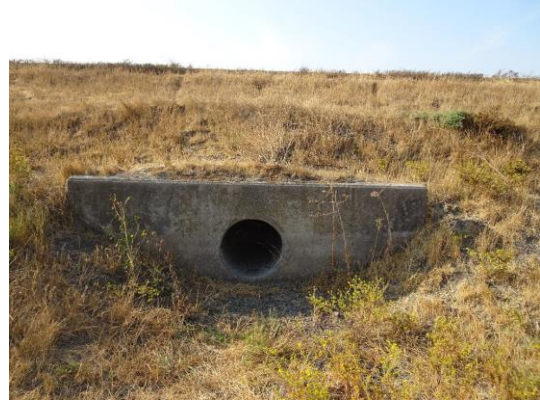
Photo 3 of 3 : UCIP_FA_2024_83235_90557.jpg

Headwall and pipe at LS toe

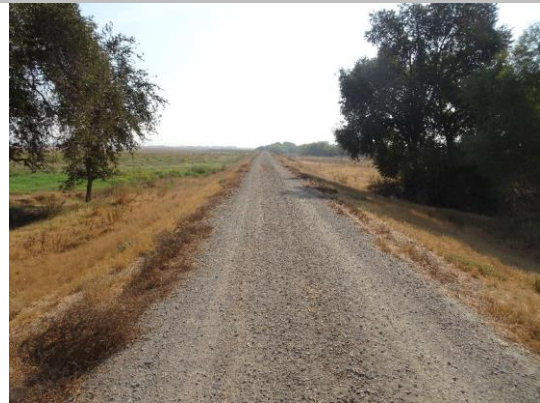
Photo 1 of 3 : UCIP_FA_2024_83236_90560.jpg

DS_ID:19587
 FS_ID:83236
 EP_NO: N/A
 Repair Type: No Action Needed
 EVAL Issue:
 Crossing Status: Found
 UCIP Comments: 04/23/2024 Record updated from Non-Urgent to No Action Needed. DMP internal video inspection has found none or minor pipe defects. (M. Thao - DWR UCIP)
 10/06/2020 Record has been updated from No Action Needed to Non-Urgent. No permit was found authorizing this encroachment. CVFPB will need to review crossing to determine owner. DWR DMP internal inspection is still pending and scheduled for 2021. (B. Singh - GEI, O. Magana - DWR UCIP)
 FIELD_STRUCT_DESC: 36-inch corrugated metal (CM) gravity drainage pipe through the levee, 12.8 feet below the crown. Flap gate on the waterside (WS) end. Brass cap No. 108 bench mark (BM) on the headwall on the landside (LS). Pipe crosses through the levee at about a 45-degree angle. [Additional Reference(s): DWR Levee Log, 2002, (HLM 1.35). USACE San Joaquin O&M Manual, Unit No. 601, Part No. 1, (SJR601.1), 1967, Revised 25 May 2011, (HLM 1.34)].

Overview of levee crown, looking US

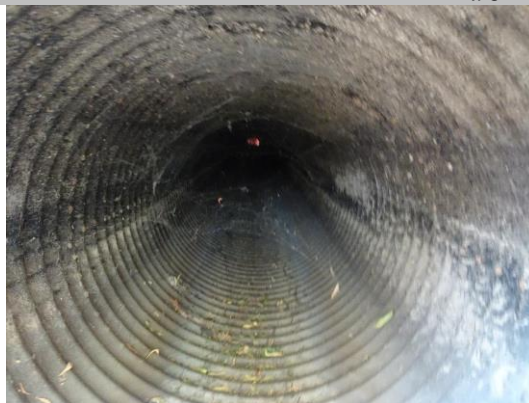
Photo 2 of 3 : UCIP_FA_2024_83236_90562.jpg

LS view: Inside pipe at LS toe

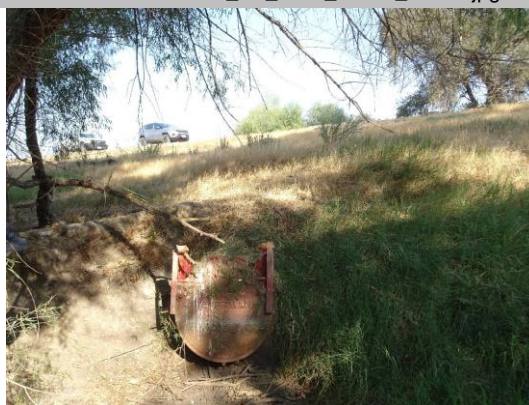
Photo 3 of 3 : UCIP_FA_2024_83236_90559.jpg

WS view: Concrete headwall and flapgate visible at WS toe

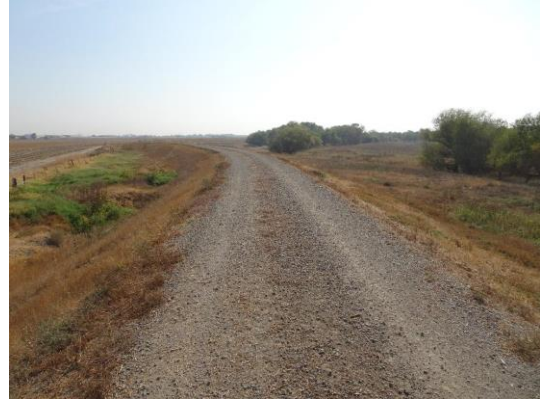
Photo 1 of 3 : UCIP_FA_2024_83238_90567.jpg

Comment Code						
Inspector Comment						
DS_ID:19588 FS_ID:83238 EP_NO: N/A Repair Type: No Action Needed EVAL Issue: Crossing Status: Found UCIP Comments: 04/23/2024 Record updated from Non-Urgent to No Action Needed. DMP internal video inspection has found none or minor pipe defects. (M. Thao - DWR UCIP) 10/06/2020 Record remains Non-Urgent. No permit was found authorizing this encroachment. CVFPB will need to review crossing to determine owner. DWR DMP has not found internal issues, LOF between 1 and 2. Recommend inspection in 5 years. (B. Singh - GEI, O. Magana - DWR UCIP) 04/08/2014 Some sediment buildup inside pipe at LS toe. Recommend contacting owner to clear sediment buildup and check wall integrity through pipe section. (W. Wylie - DWR UCIP) FIELD_STRUCT_DESC: 24-inch corrugated metal (CM) gravity drainage pipe through the levee, 11.0 feet below the crown. Flap gate on the waterside (WS) end. Brass cap No. 108 bench mark (BM) on the headwall on the landside (LS). [Additional Reference(s): DWR Levee Log, 2002, (HLM 1.48). USACE San Joaquin O&M Manual, Unit No. 601, Part No. 1, (SJR601.1), 1967, Revised 25 May 2011, (HLM 1.48)]. FS Date: 10/6/2020

Overview of levee crown, looking US

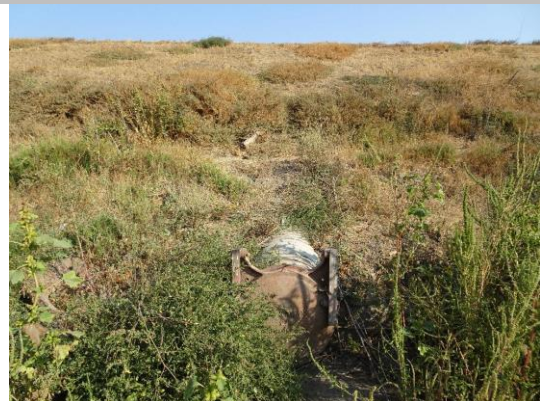
Photo 2 of 3 : UCIP_FA_2024_83238_90570.jpg

Pipe and flapgate visible on WS toe

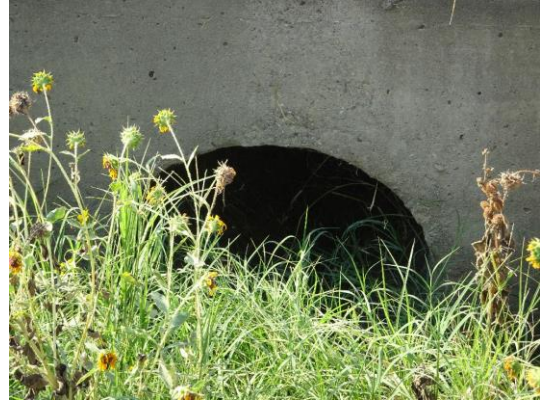
Photo 3 of 3 : UCIP_FA_2024_83238_90566.jpg

Pipe partially visible on LS toe

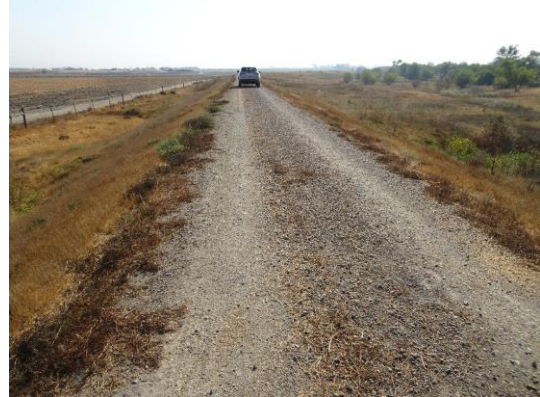
Photo 1 of 3 : UCIP_FA_2024_70644_90572.jpg

Comment Code					
Inspector Comment					
DS_ID:19589 FS_ID:70644 EP_NO: N/A Repair Type: No Action Needed EVAL Issue: Crossing Status: Found UCIP Comments: 09/15/2023 Record updated from Non-Urgent to No Action Needed. Pipe was CIPP lined. DMP internal video inspection has found none or minor pipe defects. Recommend next video inspection in 5 years. (O. Yakimov - DWR UCIP) 10/06/2020 Record remains Non-Urgent. DWR DMP has found integrity issues, LOF between 4 and 5. Crossing will be monitored until funding becomes available for rehabilitation. No permit was found authorizing this encroachment. CVFPB will need to review crossing to determine owner. Dense vegetation was found along the WS and LS toe. Recommend removing vegetation along the pipe alignment. Based on the 2014 photos, the LS toe appears to be heavily silted up. Recommend removing silt to increase flow capacity and meet pipe design capacity. (B. Singh - GEI, O. Magana - DWR UCIP) 04/08/2014 Heavy sediment buildup in pipe at LS toe. (DWR UCIP - W. Wylie) FIELD_STRUCT_DESC: 24-inch CIPP-lined corrugated metal (CM) gravity drainage pipe through the levee, 13.6 feet below the crown. Flap gate on the waterside (WS) end. Brass cap No. 108 bench mark (BM) on the headwall on the landside (LS). [Additional Reference(s): DWR Levee Log, 2002, (HLM 1.70). USACE San Joaquin O&M Manual, Unit No. 601, Part No. 1, (SJR601.1), 1967, Revised 25 May 2011, (HLM 1.69)]. FS Date: 10/6/2020

Overview of levee crown, looking US

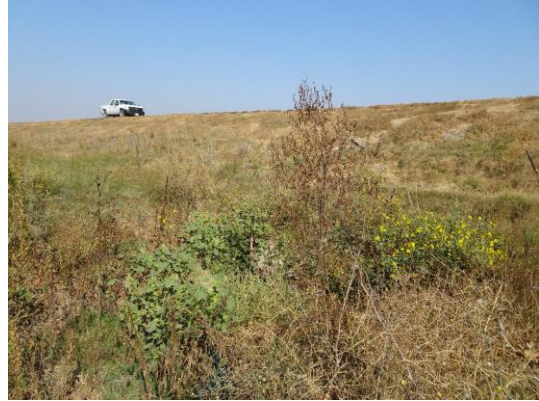
Photo 2 of 3 : UCIP_FA_2024_70644_90575.jpg

WS view: Flapgate and headwall visible at WS toe; dense vegetation

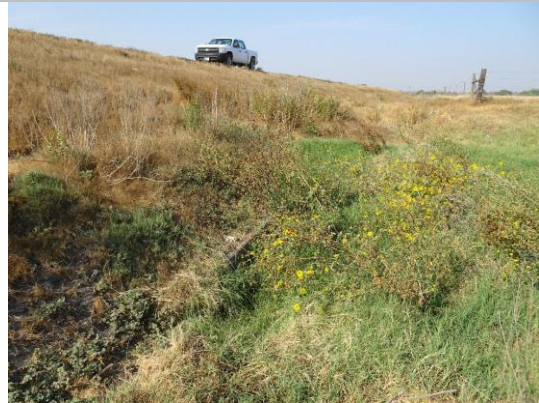
Photo 3 of 3 : UCIP_FA_2024_70644_90576.jpg

LS view: Headwall and pipe partially visible at LS toe; dense vegetation

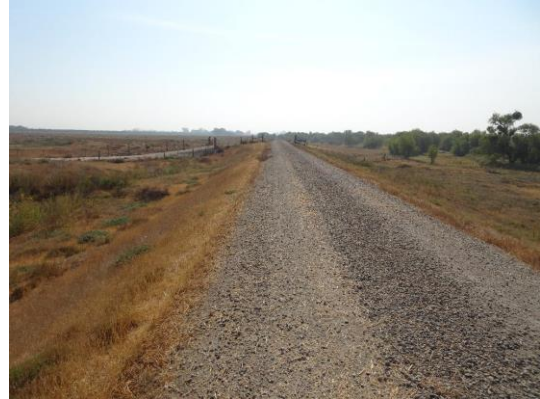
Photo 1 of 3 : UCIP_FA_2024_77847_90581.jpg

Comment Code						
Inspector Comment						
DS_ID:19590 FS_ID:77847 EP_NO: N/A Repair Type: Urgent EVAL Issue: 1, Pipe Integrity Crossing Status: Found UCIP Comments: 12/14/2022 Record updated from Non-Urgent to Urgent. DMP internal video inspection has found pipe integrity issues. LOF of crossing is between 5 and 6. Crossing will be monitored until funding becomes available to address the issues. (O.Yakimov - DWR UCIP) 10/06/2020 Record has been updated from No Action Needed to Non-Urgent. No permit was found authorizing this encroachment. CVFPB will need to review crossing to determine owner. DWR DMP internal inspection is pending and scheduled for 2021. Dense vegetation was observed along the pipe alignment and both WS and LS toe. Recommend clearing vegetation along pipe alignment. (B. Singh - GEI, O. Magana - DWR UCIP) FIELD_STRUCT_DESC: 36-inch corrugated metal (CM) gravity drainage pipe through the levee, 14.2 feet below the crown. Flap gate on the waterside (WS) end. Brass cap No. 100 bench mark (BM) on the headwall on the landside (LS). [Additional Reference(s): DWR Levee Log, 2002, (HLM 1.84). USACE San Joaquin O&M Manual, Unit No. 601, Part No. 1, (SJR601.1), 1967, Revised 25 May 2011, (HLM 1.83)]. FS Date: 10/6/2020 1:27:14 PM

Overview of levee crown, looking upstream

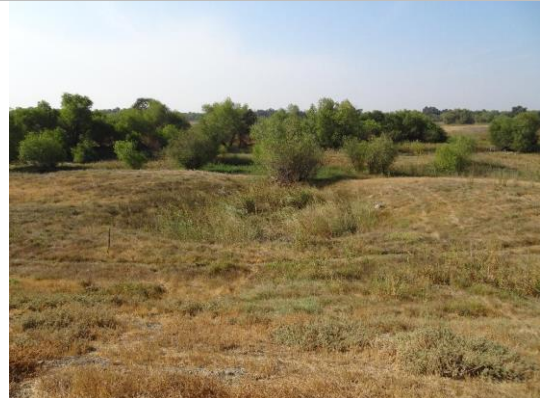
Photo 2 of 3 : UCIP_FA_2024_77847_90582.jpg

WS view: Pipe, flapgate, and headwall are not visible at WS toe from levee crown

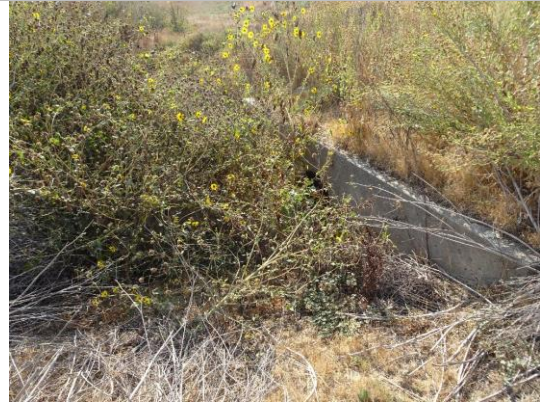
Photo 3 of 3 : UCIP_FA_2024_77847_90578.jpg

LS view: Pipe and concrete headwall partially visible at LS toe

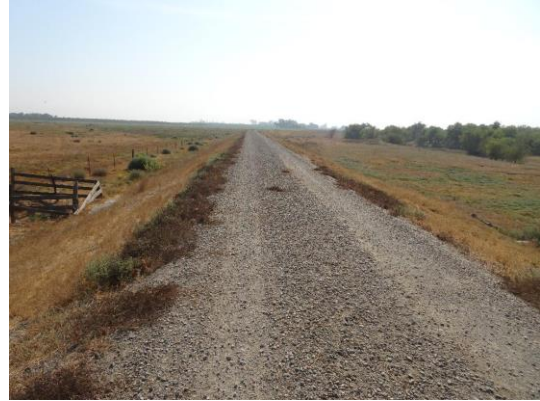
Photo 2 of 3 : UCIP_FA_2024_83239_90611.jpg

DS_ID:19591
FS_ID:83239
EP_NO: N/A
Repair Type: No Action Needed
EVAL Issue:
Crossing Status: Found
UCIP Comments: 04/23/2024 Record updated from Non-Urgent to No Action Needed. LMA has corrected the rodent activity noted in the previous inspection. DMP internal video inspection has found none or minor pipe defects. (M. Thao - DWR UCIP)
10/06/2020 Record remains Non-Urgent. Rodent activity found in the general area. No permit was found authorizing this encroachment. CVFPB will need to review crossing to determine owner. DWR DMP has not found internal issues, LOF between 1 and 2. Recommend inspection in 5 years. (B. Singh - GEI, O. Magana - DWR UCIP)
04/08/2014 Need to contact owner to determine crossing status. Inlet drop box silted in and needs to be cleaned out. (W. Wylie - DWR UCIP)
FIELD_STRUCT_DESC: 24-inch corrugated metal (CM) gravity drainage pipe through the levee, 9.7 feet below the crown. Flap gate on the waterside (WS) end. Brass cap No. 100 bench mark (BM) on the headwall on the landside (LS). Wooden barrier around drop inlet on the LS toe. [Additional Reference(s): DWR Levee Log, 2002, (HLM 1.98). USACE San Joaquin O&M Manual, Unit No. 601, Part No. 1, (SJR601.1), 1967, Revised 25 May 2011, (HLM 1.98)].

Overview of levee crown, looking US

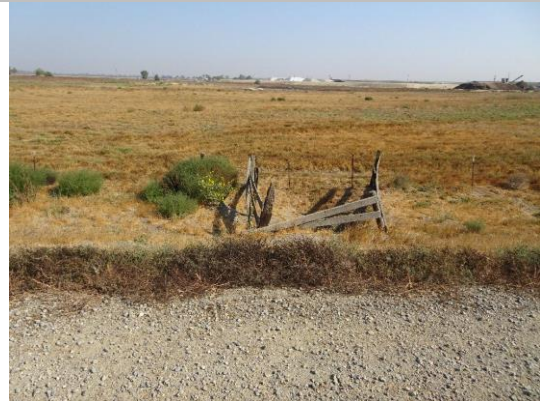
Photo 3 of 3 : UCIP_FA_2024_83239_90613.jpg

LS view: View toward LS pipe and headwall from levee crown

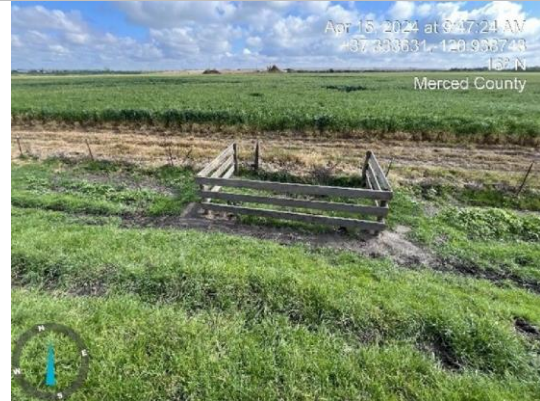
Photo 1 of 3 : UCIP_FA_2024_83241_121610.jpg

Comment Code					
Inspector Comment					
DS_ID:19570 FS_ID:83241 EP_NO: N/A Repair Type: No Action Needed EVAL Issue: Crossing Status: Found UCIP Comments: 04/23/2024 Record updated from Non-Urgent to No Action Needed. DMP internal video inspection has found none or minor pipe defects. Wooden barrier noted in the 10/06/2020 inspection surrounding drop-inlet has been corrected. (M. Thao - DWR UCIP) 12/19/2022 Record updated from Urgent to Non-Urgent. Pipe has been CIPP-lined. LOF of crossing is less or equal to 4. Recommend next video inspection in 5 years. (O. Yakimov - DWR UCIP). 10/06/2020 Record updated from Non-Urgent to Urgent. DMP internal video inspection has found pipe integrity issues. LOF of crossing is between 5 and 6. Crossing will be monitored until funding becomes available to address the issues. Wooden barrier surrounding drop-inlet is dilapidated. No permit was found authorizing this encroachment. CVFPB will need to review crossing to determine owner. (B. Singh - GEI, O. Magana - DWR UCIP) 04/08/2014 Unable to find inlet on landward toe. Recommend clearing vegetation on landward side to properly inspect inlet. (W. Wylie - DWR UCIP) FIELD_STRUCT_DESC: 24-inch CIPP-lined corrugated metal (CM) gravity drainage pipe through the levee, 9.8 feet below the crown. Flap gate on the waterside (WS) end. Brass cap No. 100 bench mark (BM) on the headwall on the landside (LS). [Additional Reference(s): DWR Levee Log, 2002, (HLM 2.08). USACE San Joaquin O&M Manual, Unit No. 601, Part No. 1, (SJR601.1), 1967, Revised 25 May 2011, (HLM 2.08)]. FS Date: 10/6/2020 4:15:32 PM

LS view: Corrected wood barrier around drop-inlet on LS toe (photo sent by LMA).

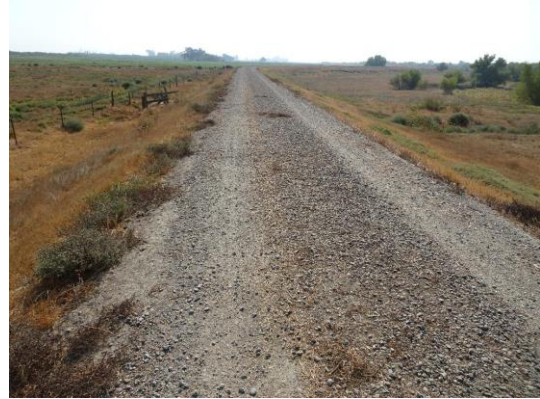
Photo 2 of 3 : UCIP_FA_2024_83241_90617.jpg

Overview of levee crown, looking US

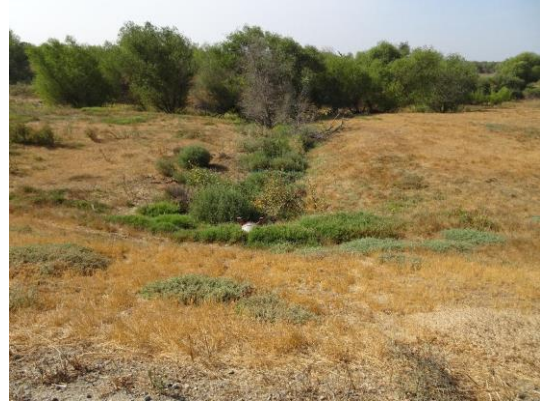
Photo 3 of 3 : UCIP_FA_2024_83241_90618.jpg

WS view: Pipe and flapgate visible on WS toe

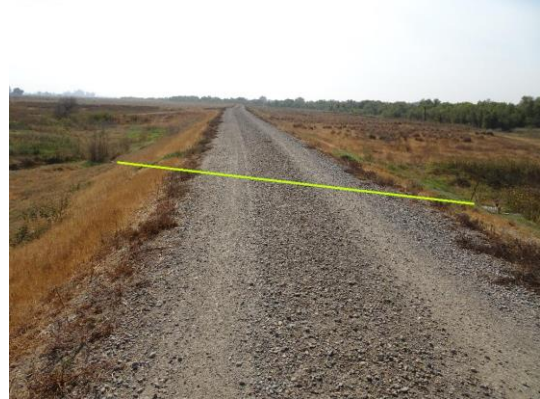
Photo 1 of 3 : UCIP_FA_2024_77843_90625.jpg

DS_ID:19571
FS_ID:77843
EP_NO: N/A
Repair Type: Urgent
EVAL Issue: 1, Pipe Integrity
Crossing Status: Found
UCIP Comments: 12/14/2022 Record updated from Non-Urgent to Urgent. DMP internal video inspection has found pipe integrity issues. LOF of crossing is between 5 and 6. Crossing will be monitored until funding becomes available to address the issues. (O.Yakimov - DWR UCIP)
10/06/2020 Record has been updated from No Action Needed to Non-Urget. Pipe angle through the levee. System description has been updated. No permit was found authorizing this encroachment. CVFPB will need to review crossing to determine owner. DWR DMP internal inspection is pending and scheduled for 2021. (B. Singh - GEI, O. Magana - DWR UCIP)
FIELD_STRUCT_DESC: 36-inch corrugated metal (CM) gravity drainage pipe through the levee at an angle, 12.6 feet below the crown. Flap gate on the waterside (WS) end. Brass cap No. 100 bench mark (BM) on the headwall on the landside (LS). Wooden barrier around drop inlet on the LS toe. [Additional Reference(s): DWR Levee Log, 2002, (HLM 2.25). USACE San Joaquin O&M Manual, Unit No. 601, Part No. 1, (SJR601.1), 1967, Revised 25 May 2011, (HLM 2.25)].

Overview of levee crown, looking US. Pipe angled through levee at alignment shown

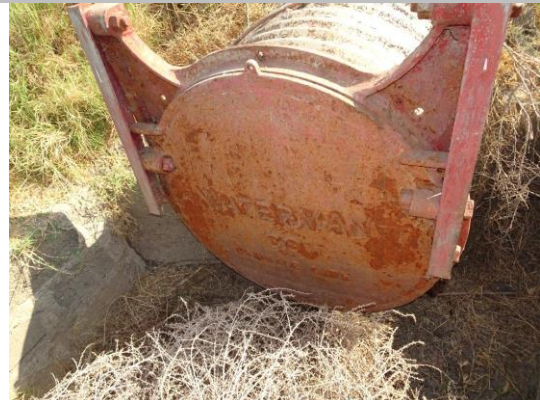
Photo 2 of 3 : UCIP_FA_2024_77843_90628.jpg

WS view: Pipe, flapgate, and headwall on WS toe

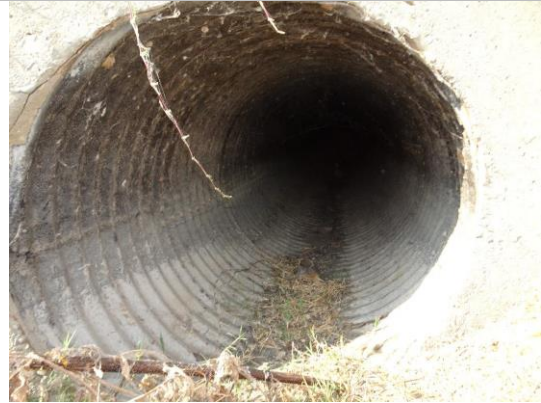
Photo 3 of 3 : UCIP_FA_2024_77843_90623.jpg

LS view: inside view of pipe

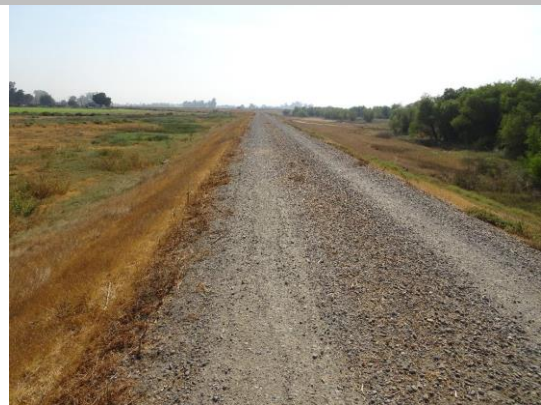
Photo 1 of 3 : UCIP_FA_2024_70649_90632.jpg

DS_ID:19572
FS_ID:70649
EP_NO: N/A
Repair Type: Non-Urgent
EVAL Issue:
Crossing Status: Found
UCIP Comments: 10/06/2020 Record has been updated from No Action Needed to Non-Urgent. No permit was found authorizing this encroachment. CVFPB will need to review crossing to determine owner. DWR DMP has not found internal issues, LOF between 1 and 2. Recommend inspection in 5 years. (B. Singh - GEI, O. Magana - DWR UCIP)
FIELD_STRUCT_DESC: 24-inch corrugated metal (CM) gravity drainage pipe through the levee, 8.0 feet below the crown. Flap gate on the waterside (WS) end. Brass cap No. 100 bench mark (BM) on the headwall on the landside (LS). [Additional Reference(s): DWR Levee Log, 2002, (HLM 2.53). USACE San Joaquin O&M Manual, Unit No. 601, Part No. 1, (SJR601.1), 1967, Revised 25 May 2011, (HLM 2.52)].
FS Date: 10/6/2020

Overview of levee crown, looking US

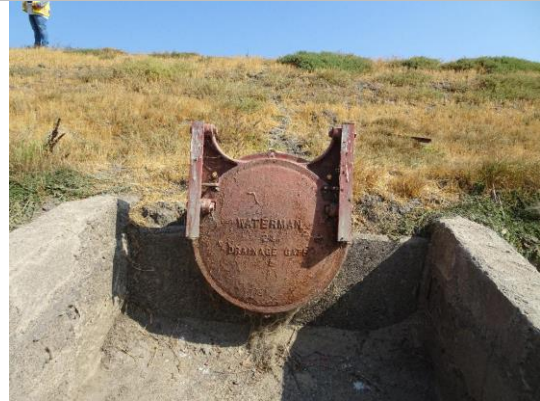
Photo 2 of 3 : UCIP_FA_2024_70649_90635.jpg

WS view: Pipe, flapgate, and headwall on WS toe

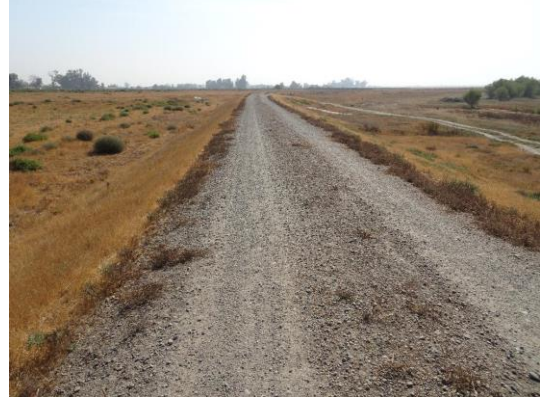
Photo 1 of 3 : UCIP_FA_2024_70650_90637.jpg

Comment Code					
Inspector Comment					
DS_ID:19573 FS_ID:70650 EP_NO: N/A Repair Type: Non-Urgent EVAL Issue: Crossing Status: Found UCIP Comments: 10/06/2020 Record remains Non-Urgent. No permit was found authorizing this encroachment. CVFPB will need to review crossing to determine owner. DWR DMP has not found internal issues, LOF between 1 and 2. Recommend inspection in 5 years. (B. Singh - GEI, O. Magana - DWR UCIP) 04/08/2014 Sedimentation in pipe at landward toe. (W. Wylie - DWR UCIP) FIELD_STRUCT_DESC: 24-inch corrugated metal (CM) gravity drainage pipe through the levee, 7.3 feet below the crown. Flap gate on the waterside (WS) end. Brass cap No. 100 bench mark (BM) on the headwall on the landside (LS). [Additional Reference(s): DWR Levee Log, 2002, (HLM 2.71). USACE San Joaquin O&M Manual, Unit No. 601, Part No. 1, (SJR601.1), 1967, Revised 25 May 2011, (HLM 2.70)]. FS Date: 10/6/2020

Overview of levee crown, looking US

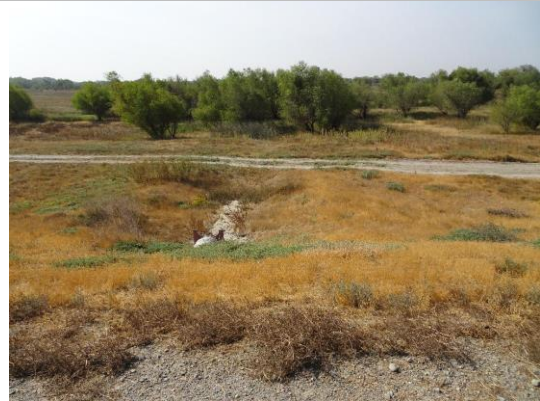
Photo 2 of 3 : UCIP_FA_2024_70650_90638.jpg

WS view: Pipe and flapgate visible on WS toe

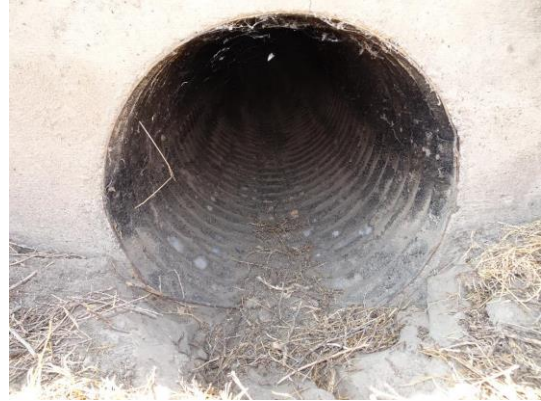
Photo 3 of 3 : UCIP_FA_2024_70650_90642.jpg

WS view: Pipe and headwall at WS toe

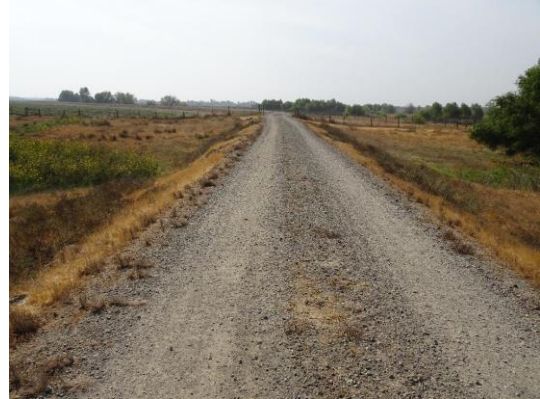
Photo 1 of 3 : UCIP_FA_2024_77846_90644.jpg

DS_ID:19574
FS_ID:77846
EP_NO: N/A
Repair Type: Urgent
EVAL Issue: 1, Pipe Integrity
Crossing Status: Found
UCIP Comments: 12/14/2022 Record updated from Non-Urgent to Urgent. DMP internal video inspection has found pipe integrity issues. LOF of crossing is between 5 and 6. Crossing will be monitored until funding becomes available to address the issues. (O.Yakimov - DWR UCIP)
10/06/2020 Record remains Non-Urgent. No permit was found authorizing this encroachment. CVFPB will need to review crossing to determine owner. DWR DMP internal inspection is pending and scheduled for 2021. (B. Singh - GEI, O. Magana - DWR UCIP)
04/08/2014 Some minor erosion around headwall on LS toe. (W. Wylie - DWR UCIP)
FIELD_STRUCT_DESC: 36-inch corrugated metal (CM) gravity drainage pipe through the levee, 8.0 feet below the crown. Flap gate on the waterside (WS) end. Brass cap No. 100 bench mark (BM) on the headwall on the landside (LS). [Additional Reference(s): DWR Levee Log, 2002, (HLM 3.17). USACE San Joaquin O&M Manual, Unit No. 601, Part No. 1, (SJR601.1), 1967, Revised 25 May 2011, (HLM 3.16)].

Overview of levee crown, looking US

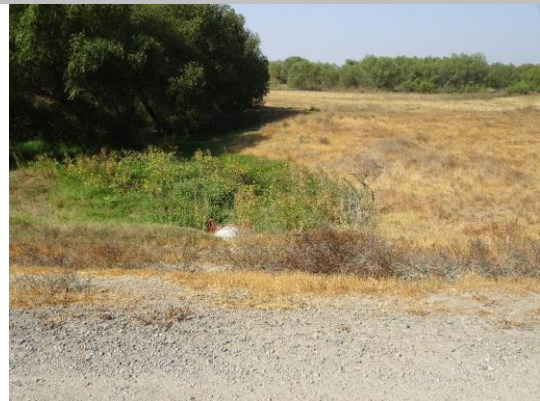
Photo 2 of 3 : UCIP_FA_2024_77846_90645.jpg

WS view: Pipe and flapgate visible at WS toe

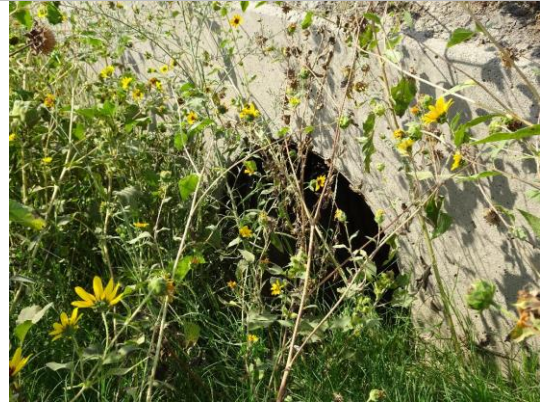
Photo 3 of 3 : UCIP_FA_2024_77846_90648.jpg

LS view: Pipe and headwall at LS toe. Heavy vegetation.

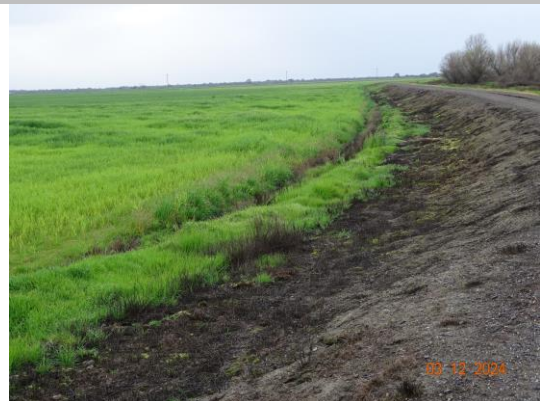
Photo 1 of 1 : FA_2024_NA0010_118_117_20240828_00016.jpg

LM Start	3.23	Rating **	M	Issue No.	117
LM End	3.90	Issue Type +	En	Location *	LS
Category	Earthen Levee			GPS Latitude/Longitude	
				Start	End
Item	Encroachments			37.320029 °	37.311311 °
				-120.928556 °	-120.927310 °
DWR ID	DWR_NA0010_01_f_2018_117				
Comment Code					
DT : Ditch					
Inspector Comment					
Earthen ditch along landside toe.

Small ditch along the landside toe. (Spring 2024)

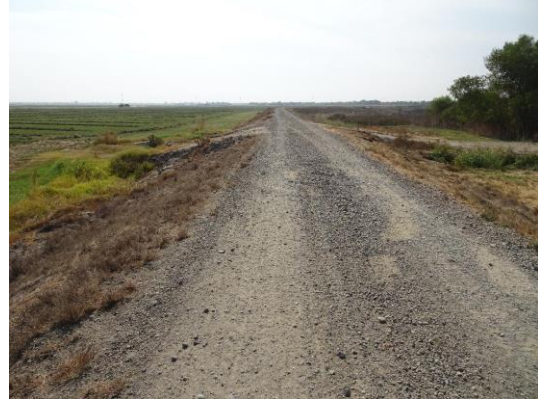
Photo 1 of 3 : UCIP_FA_2024_70652_90588.jpg

DS_ID:19575
FS_ID:70652
EP_NO: N/A
Repair Type: Urgent
EVAL Issue: 1, Pipe Integrity
Crossing Status: Found
UCIP Comments: 06/05/2024 Minor Alteration Work authorization No. WA2024094 issued for pipe replacement. Construction not yet started. (O. Yakimov - DWR UCIP)
10/06/2020 Record remains Urgent. Sinkhole present directly above the LS headwall and along pipe alignment. Pipe collapse visible from from the LS toe. Erosion present on the WS just behind the flap gate. No permit was found authorizing this encroachment. CVFPB will need to review crossing to determine owner. DWR DMP internal inspection is pending and scheduled in 2021. (B. Singh - GEI, O. Magana - DWR UCIP)
10/01/2018 Pipe continues to rust through, causing the pipe to collapse on the LS. Sediment buildup visible from the LS inlet. Loss of soil just above the LS concrete headwall and along the LS slope. Crossing remains Urgent due to the levee slope issues and pipe failure through the levee. (O. Magana - DWR UCIP)

07/19/2016 Same as previous inspection. Erosion present on LS slope. (O. Magana - DWR UCIP)
04/08/2014 Pipe rusted through at Springline on LS toe. Flapgate blocked by sediment on WS toe. Heavy sediment on both ends of pipe. Need to contact owner to address issues. (W. Wylie - DWR UCIP)
FIELD_STRUCT_DESC: 36-inch corrugated metal (CM) gravity drainage pipe through the levee, 9.7 feet below the crown. Flap gate on the waterside (WS) end. Brass cap No. 100 bench mark (BM) on the headwall on the landside (LS). [Additional Reference(s): DWR Levee Log, 2002, (HLM 3.50). USACE San Joaquin O&M Manual, Unit No. 601, Part No. 1, (SJR601.1), 1967, Revised 25 May 2011, (HLM 3.50)].
FS Date: 10/6/2020

Overview of levee crown, looking US

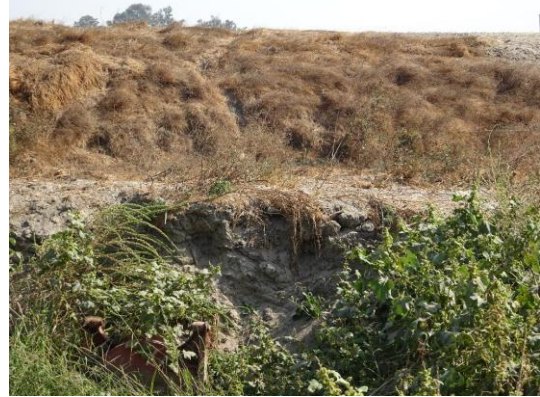
Photo 2 of 3 : UCIP_FA_2024_70652_90586.jpg

WS view: Slope from WS toe

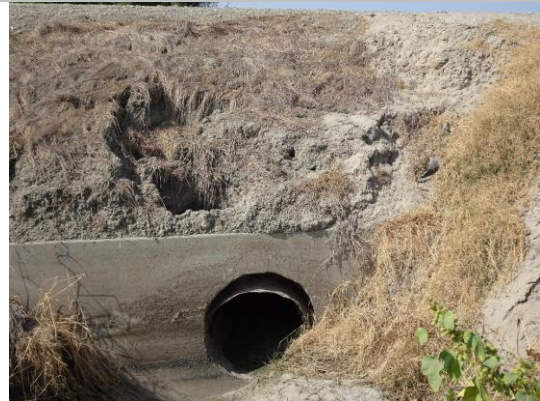
Photo 3 of 3 : UCIP_FA_2024_70652_90591.jpg

LS view: Pipe, headwall, and sinkhole at LS toe

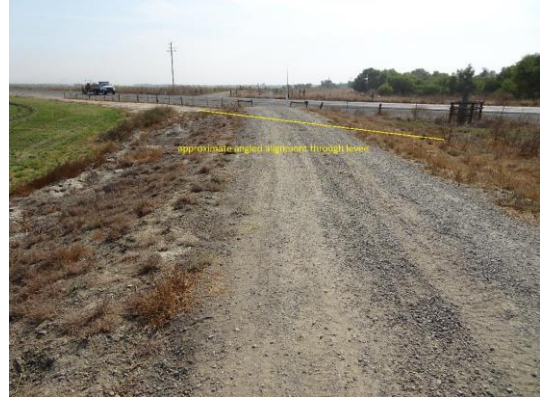
Photo 1 of 3 : UCIP_FA_2024_70653_90650.jpg

Comment Code						
Inspector Comment						
DS_ID:19576 FS_ID:70653 EP_NO: N/A Repair Type: Urgent EVAL Issue: 3a, Flood Risk Crossing Status: Found UCIP Comments: 10/06/2020 Record updated from Non-Urgent to Urgent. Heavy siltation through the length of the pipe was observed and recommend removal. Flap gate is missing on the WS toe. Recommend adding flap gate to prevent flooding from the WS to the LS. No permit was found authorizing this encroachment. CVFPB will need to review crossing to determine owner. DWR DMP internal inspection is pending and scheduled for 2021. Pipe goes through the levee at an angle. System description has been updated to include angled pipe information.(B. Singh - GEI, O. Magana - DWR UCIP) 10/08/2014 Slide gate missing from WS. No closure device, but degrading of levee at Highway 140 is lower than pipe, so this does not appear to be a critical issue. Also dense vegetation limits the inspector's visibility to identify signs of pipe failure (leaks) along the slope. Recommend removing vegetation along pipe alignment to conduct proper inspection of structure and appurtenances. (W. Wylie - DWR UCIP) FIELD_STRUCT_DESC: 30-inch corrugated metal (CM) gravity drainage pipe through the levee at an angle, 3.5 feet below the crown. Flap gate on the waterside (WS) end. Brass cap No. 100 bench mark (BM) on the headwall on the landside (LS). [Additional Reference(s): DWR Levee Log, 2002, (HLM 3.95). USACE San Joaquin O&M Manual, Unit No. 601, Part No. 1, (SJR601.1), 1967, Revised 25 May 2011, (HLM 3.95)]. FS Date: 10/6/2020

Overview of levee crown, looking US. Angled pipe alignment through levee crown approximated.

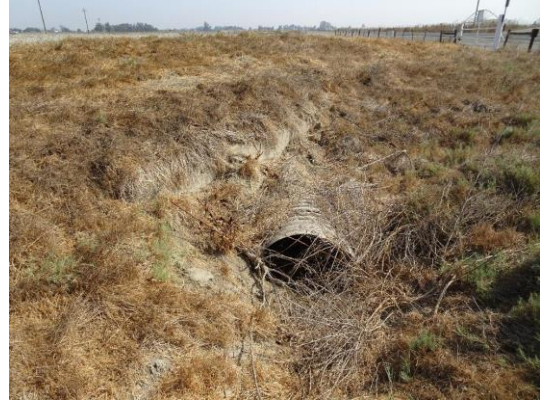
Photo 2 of 3 : UCIP_FA_2024_70653_90652.jpg

WS view: Heavy siltation at WS invert. Pipe flapgate missing at WS toe.

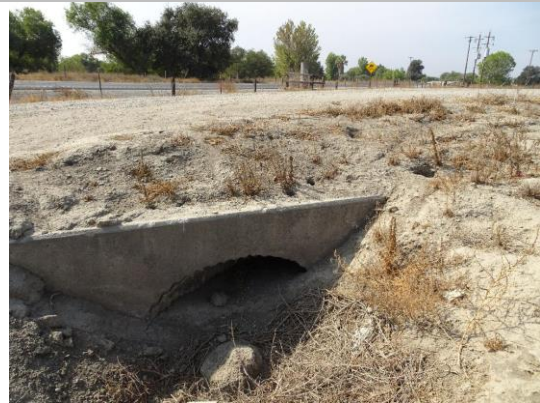
Photo 3 of 3 : UCIP_FA_2024_70653_90655.jpg

LS view: Pipe and headwall at LS toe. Heavy siltation at invert.

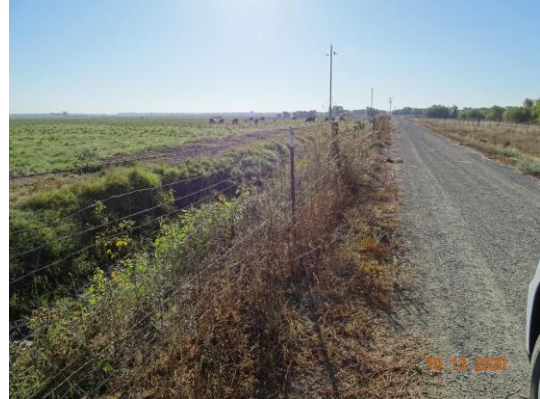
Photo 1 of 1 : FA_2024_NA0010_118_118_20240828_00017.jpg

LM Start	3.99	Rating **	M	Issue No.	118
LM End	4.25	Issue Type +	En	Location *	LS
Category	Earthen Levee			GPS Latitude/Longitude	
				Start	End
Item	Encroachments			37.310693 °	37.307895 °
				-120.926024 °	-120.922935 °
DWR ID	DWR_NA0010_01_f _ 2018_118				
Comment Code					
FE : Fence					
Inspector Comment					
Fence along landside toe.

View of fence on the landside shoulder and toe. (Fall 2020)

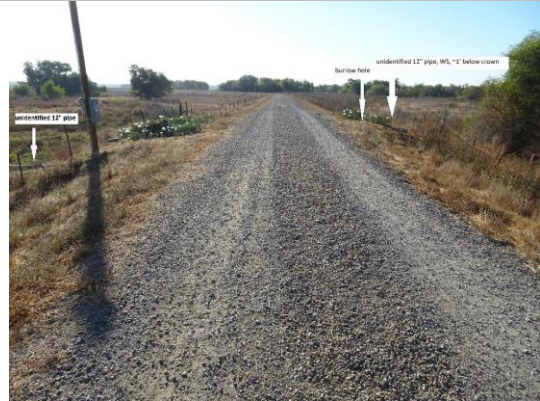
Photo 1 of 3 : UCIP_FA_2024_70655_90661.jpg

Comment Code						
Inspector Comment						
DS_ID:19607 FS_ID:70655 EP_NO: N/A Repair Type: Non-Urgent EVAL Issue: 10, Unauthorized Modification or Non-Compliant Permit Crossing Status: Found UCIP Comments: 10/20/2020 Record remains Non-Urgent. Barbed wire prevented access to the pipe located on the LS toe. Unpermitted modifications were made to the structure. There appears to be multiple crossings at this location, two 12-inch pipes and 48-inch refurbished pipe. Recommend adding new DSID for the second 12-inch pipe found during field inspection. Portion of concrete headwall visible on the WS toe that corresponds to 48-inch pipe. Recommend contacting owner to determine status of structure and obtain as-builts. No permit was found authorizing these encroachments. CVFPB will need to review crossing to determine owner(s). (B. Singh - GEI, O. Magana - DWR UCIP) UCIP#108/2014 Pipe appears sleeved with a 12-inch steel pipe with a slide gate at the LS toe. No identified authorization for changes to this crossing. Need to contact owner to obtain additional information about the modifications to crossing. (W. Wylie - DWR UCIP) FIELD_STRUCT_DESC: 48-inch corrugated metal (CM) gravity drainage pipe through the levee, 14.0 feet below the crown. Flap gate on the waterside (WS) end. Brass cap No. 90 bench mark (BM) on the headwall on the landside (LS). [Additional Reference(s): DWR Levee Log, 2002, (HLM 4.16). USACE San Joaquin O&M Manual, Unit No. 601, Part No. 1, (SJR601.1), 1967, Revised 25 May 2011, (HLM 4.16)]. FS Date: 10/20/2020

Overview of levee crown showing location of burrow hole and alignment of unauthorized 12" pipe

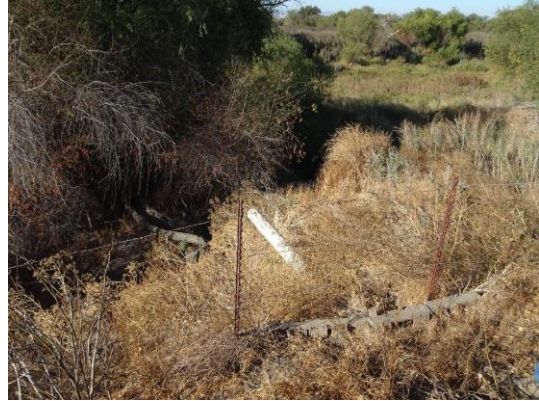
Photo 2 of 3 : UCIP_FA_2024_70655_90662.jpg

WS view: Unauthorized 12-inch PVC pipe on WS, approximately 1 foot below levee crown.

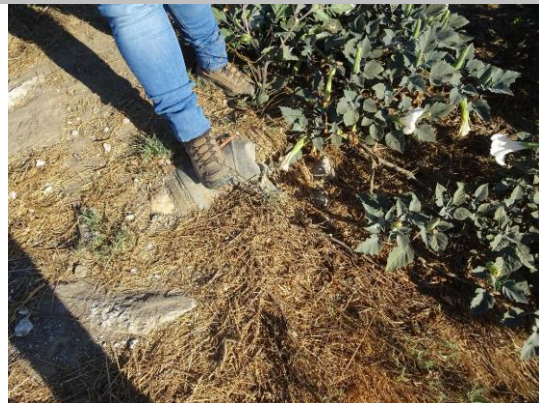
Photo 3 of 3 : UCIP_FA_2024_70655_90665.jpg

LS view: Abandoned pipe through levee crown

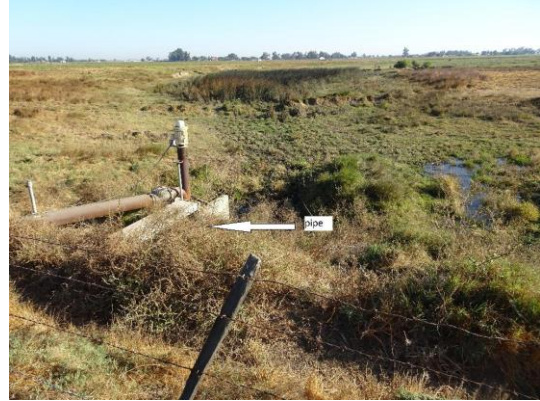
Photo 1 of 1 : UCIP_FA_2024_70656_90667.jpg

Comment Code					
Inspector Comment					
DS_ID:24866 FS_ID:70656 EP_NO: N/A Repair Type: Non-Urgent EVAL Issue: 10, Unauthorized Modification or Non-Compliant Permit Crossing Status: Found UCIP Comments: 10/20/2020 Record remains Non-Urgent. Barbed wire prevented access to the pipe located on the LS toe. Unpermitted modifications were made to the structure. There appears to be multiple crossings at this location, two 12-inch pipes and 48-inch refurbished pipe. Recommend contacting owner to determine status of structure and obtain as-builts. No permit was found authorizing these encroachments. CVFPB will need to review crossing to determine owner(s). (B. Singh - GEI, O. Magana - DWR UCIP) 04/08/2014 Need to contact owner to get details of crossing. (W. Wylie - DWR UCIP) FIELD_STRUCT_DESC: 12-inch steel drainage discharge pipe through the levee, 2.5 feet below the crown. 12-inch steel pipe, vent, and pump on stand visible on the landside (LS) slope. 10-inch polyvinyl chloride (PVC) pipe visible on the waterside (WS) slope. FS Date: 10/20/2020

LS view: Location of pipe. Inspection inhibited by barbed wire fencing and dense vegetation

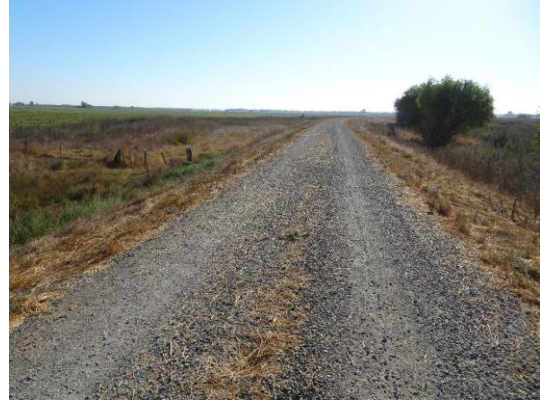
Photo 1 of 3 : UCIP_FA_2024_77849_90668.jpg

Comment Code						
Inspector Comment						
DS_ID:19608 FS_ID:77849 EP_NO: N/A Repair Type: Urgent EVAL Issue: 1, Pipe Integrity Crossing Status: Found UCIP Comments: 06/05/2024 Minor Alteration Work authorization No. WA2024094 issued for pipe replacement. Construction not yet started. (O. Yakimov - DWR UCIP) 12/14/2022 Record updated from Non-Urgent to Urgent. DMP internal video inspection has found pipe integrity issues. LOF of crossing is between 5 and 6. Crossing will be monitored until funding becomes available to address the issues. (O.Yakimov - DWR UCIP) 10/20/2020 Record remains Non-Urgent. Fence and dense vegetation prevented full inspection along the WS and LS slopes. Burrowing observed on LS and WS slopes. No permit was found authorizing this encroachment. CVFPB will need to review crossing to determine owner. DWR DMP internal inspection is pending and scheduled for 2021. (B. Singh - GEI, O. Magana - DWR UCIP) 04/08/2014 Dense vegetation and fence limits the inspector's visibility to identify signs of pipe failure (leaks) along the landward side. Recommend obtaining access to landward toe and removing vegetation along pipe alignment to conduct proper inspection of structure and appurtenances. (W. Wylie - DWR UCIP) FIELD_STRUCT_DESC: 24-inch corrugated metal (CM) gravity drainage pipe through the levee, 11.9 feet below the crown. Flap gate on the waterside (WS) end. Brass cap No. 90 bench mark (BM) on the headwall on the landside (LS). [Additional Reference(s): DWR Levee Log, 2002, (HLM 4.27). USACE San Joaquin O&M Manual, Unit No. 601, Part No. 1, (SJR601.1), 1967, Revised 25 May 2011, (HLM 4.27)]. FS Date: 10/20/2020 1:31:03 PM

Overview of levee crown, looking US

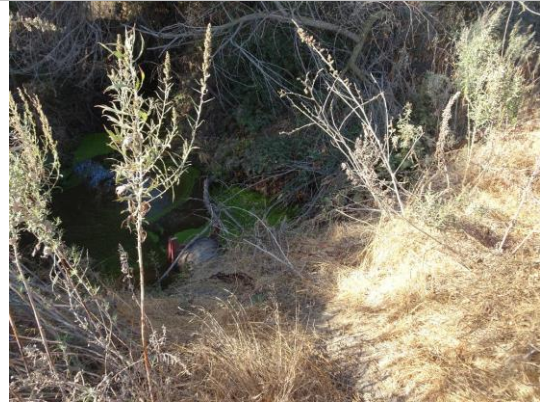
Photo 2 of 3 : UCIP_FA_2024_77849_90672.jpg

WS view: Pipe and flapgate visible at WS toe. Further inspection inhibited by barbed wire fencing
