Flood Control Project Maintenance Levee Inspections

Fall 2024 Levee Maintenance Deficiency Summary Report

San Joaquin River Basin

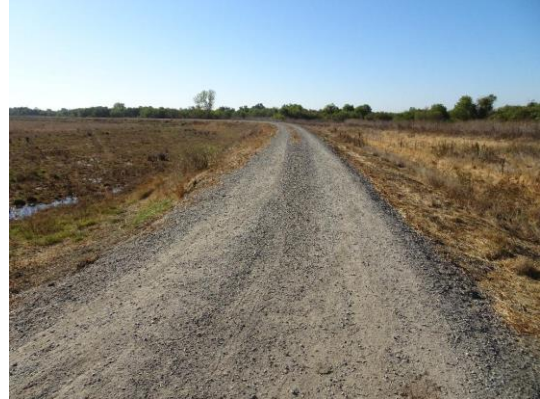
Photo 1 of 3 : UCIP_FA_2024_70658_90676.jpg

Comment Code						
Inspector Comment						
DS_ID:19609 FS_ID:70658 EP_NO: N/A Repair Type: Urgent EVAL Issue: 1, Pipe Integrity Crossing Status: Found UCIP Comments: 10/20/2020 Record has been updated from Non-Urgent to Urgent. DWR DMP has found integrity issues, LOF, between 5 and 6. Crossing will be monitored until funding becomes available to address. Evidence of the landslide visible on the LS slope from the levee crown. No permit was found authorizing this encroachment. CVFPB will need to review crossing to determine owner. (B. Singh - GEI, O. Magana - DWR UCIP) 4/08/2014 Dense vegetation limits the inspector's visibility to identify signs of pipe failure (leaks) along the waterward side. Recommend removing vegetation along pipe alignment to conduct proper inspection of structure and appurtenances. (W. Wylie - DWR UCIP) FIELD_STRUCT_DESC: 24-inch corrugated metal (CM) gravity drainage pipe through the levee, 10.0 feet below the crown. Flap gate on the waterside (WS) end. Brass cap No. 90 bench mark (BM) on the headwall on the landside (LS). [Additional Reference(s): DWR Levee Log, 2002, (HLM 4.73). USACE San Joaquin O&M Manual, Unit No. 601, Part No. 1, (SJR601.1), 1967, Revised 25 May 2011, (HLM 4.72)]. FS Date: 10/20/2020

Overview of levee crown, looking US

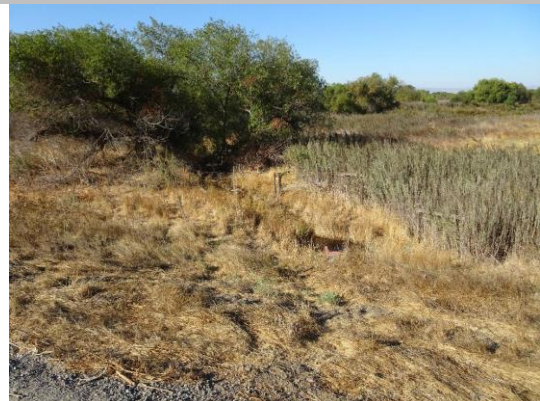
Photo 2 of 3 : UCIP_FA_2024_70658_90678.jpg

WS view: Pipe and flapgate visible at WS toe

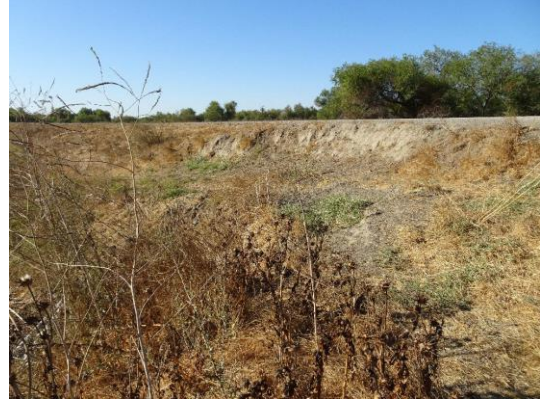
Photo 3 of 3 : UCIP_FA_2024_70658_90681.jpg

LS view: land movement/scarp of LS slope at levee crown

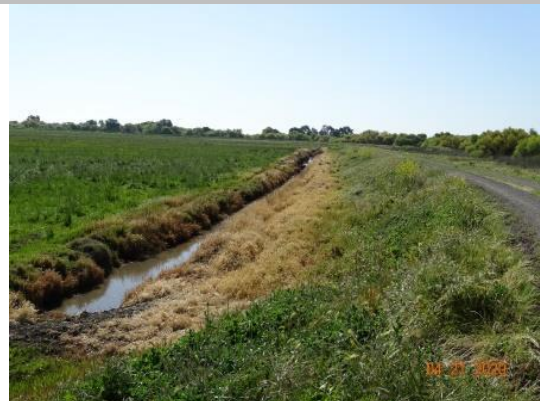
Photo 1 of 1 : FA_2024_NA0010_118_107_20240828_00010.jpg

LM Start	4.77	Rating **	M	Issue No.	107
LM End	5.32	Issue Type +	En	Location *	LS
Category	Earthen Levee			GPS Latitude/Longitude	
				Start	End
Item	Encroachments			37.301269 °	37.300396 °
				-120.920660 °	-120.912625 °
DWR ID	DWR_NA0010_01_s_2019_107				
Comment Code					
DT : Ditch					
Inspector Comment					
Ditch it roughly 8-15 ft away from levee toe.

Looking upstream at an irrigation ditch along the landside toe. (Spring 2020)

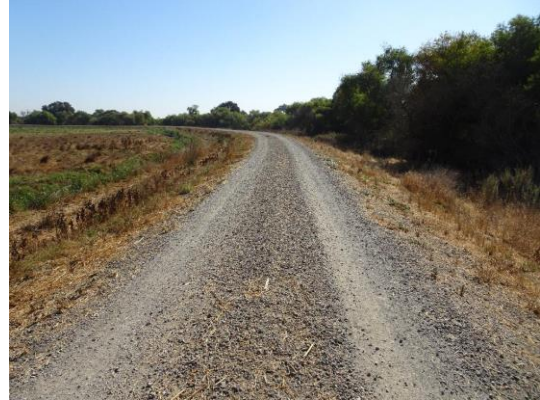
Photo 1 of 3 : UCIP_FA_2024_70659_90682.jpg

Comment Code						
Inspector Comment						
DS_ID:19610 FS_ID:70659 EP_NO: N/A Repair Type: Non-Urgent EVAL Issue: Crossing Status: Found UCIP Comments: 06/05/2024 Minor Alteration Work authorization No. WA2024094 issued for pipe replacement. Construction not yet started. (O. Yakimov - DWR UCIP) 10/20/2020 Record remains Non-Urgent. Unable to locate inlet on the LS toe. Ditch runs along the LS toe. Ditch was running full and no signs of pipe inlet were visible. This pipe appears to be non-functional--only WS pipe outlet found. No permit was found authorizing this encroachment. CVFPB will need to review crossing to determine owner. DWR DMP internal inspection is pending and scheduled for 2021. (B. Singh - GEI, O. Magana - DWR UCIP) 04/08/2014 Non-functional -- sediment buildup against flapgate and inlet buried at landward side. (W. Wylie - DWR UCIP) FIELD_STRUCT_DESC: 24-inch corrugated metal (CM) gravity drainage pipe through the levee, 8.0 feet below the crown. Flap gate on the waterside (WS) end. Brass cap No. 90 bench mark (BM) on the headwall on the landside (LS). Drainage ditch along the LS toe. [Additional Reference(s): DWR Levee Log, 2002, (HLM 5.06). USACE San Joaquin O&M Manual, Unit No. 601, Part No. 1, (SJR601.1), 1967, Revised 25 May 2011, (HLM 5.05)]. FS Date: 10/20/2020

Overview of levee crown, looking US

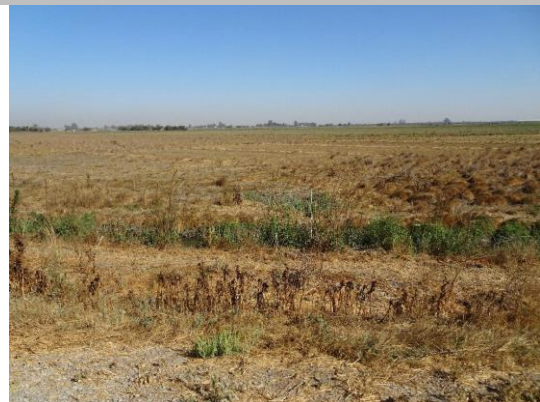
Photo 2 of 3 : UCIP_FA_2024_70659_90683.jpg

LS view: Pipe and headwall not visible at LS toe from levee crown

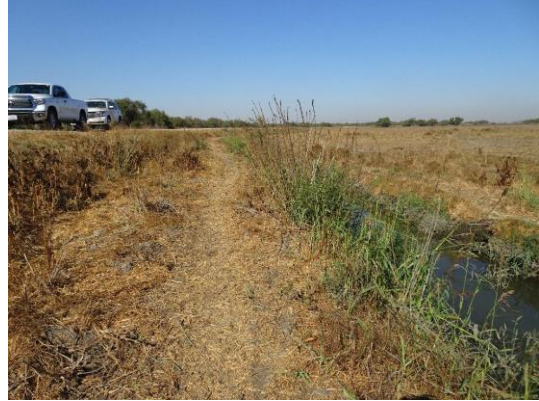
Photo 3 of 3 : UCIP_FA_2024_70659_90685.jpg

LS view: LS pipe and headwall not accessible/visible due to high vegetation

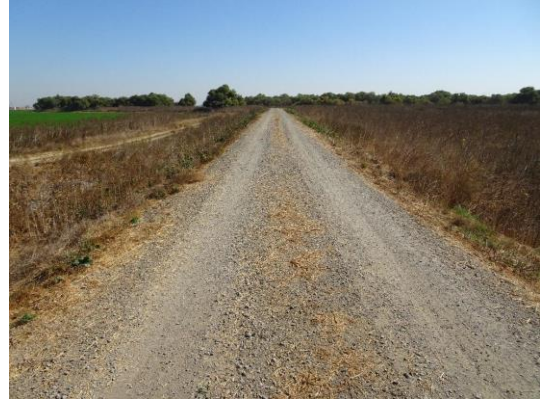
Photo 1 of 3 : UCIP_FA_2024_77850_90689.jpg

Comment Code						
Inspector Comment						
DS_ID:19611 FS_ID:77850 EP_NO: N/A Repair Type: Urgent EVAL Issue: 1, Pipe Integrity Crossing Status: Found UCIP Comments: 06/05/2024 Minor Alteration Work authorization No. WA2024094 issued for pipe replacement. Construction not yet started. (O. Yakimov - DWR UCIP) 12/14/2022 Record updated from Non-Urgent to Urgent. DMP internal video inspection has found pipe integrity issues. LOF of crossing is between 5 and 6. Crossing will be monitored until funding becomes available to address the issues. (O.Yakimov - DWR UCIP) 10/20/2020 Record remains Non-Urgent. Depression observed across levee crown, less than 6 inches in depth. Pipe inlet located at the LS toe is completely blocked by soil. This crossing is non-functional. Recommend evaluating the purpose of this drainage structure. No permit was found authorizing this encroachment. CVFPB will need to review crossing to determine owner. DWR DMP internal inspection is pending and scheduled for 2021. Recommend reviewing DMP's internal inspection when completed to investigate reason for depression across the levee crown. (B. Singh - GEI, O. Magana - DWR UCIP) 04/08/2014 Dense vegetation limits the inspector's visibility to identify signs of pipe failure (leaks) along waterward and landward slopes. Recommend removing vegetation along pipe alignment to conduct proper inspection of structure and appurtenances. Landward side filled in with soil. Need to contact owner. If crossing is no longer used need to coordinate with CVFPB for proper abandonment. (W. Wylie - DWR UCIP) FIELD_STRUCT_DESC: 24-inch corrugated metal (CM) gravity drainage pipe through the levee, 8.6 feet below the crown. Flap gate on the waterside (WS) end. Brass cap No. 90 bench mark (BM) on the headwall on the landside (LS). [Additional Reference(s): DWR Levee Log, 2002, (HLM 5.96). USACE San Joaquin O&M Manual, Unit No. 601, Part No. 1, (SJR601.1), 1967, Revised 25 May 2011, (HLM 5.95)]. FS Date: 10/20/2020 1:32:14 PM

Overview of levee crown, looking US

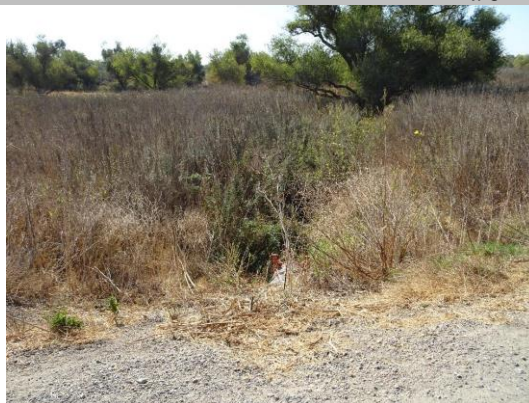
Photo 2 of 3 : UCIP_FA_2024_77850_90691.jpg

WS view: Pipe and flapgate visible at WS toe

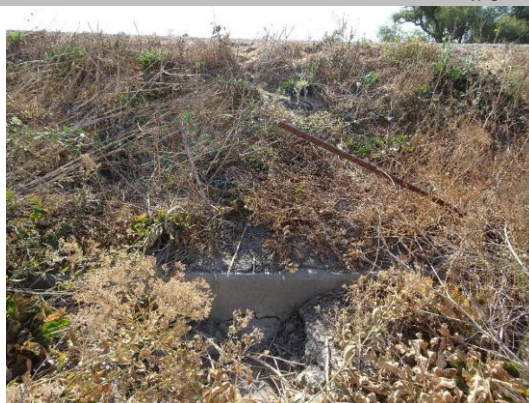
Photo 3 of 3 : UCIP_FA_2024_77850_90692.jpg

LS view: Headwall at LS toe. Pipe is completely blocked by heavy siltation at LS invert.

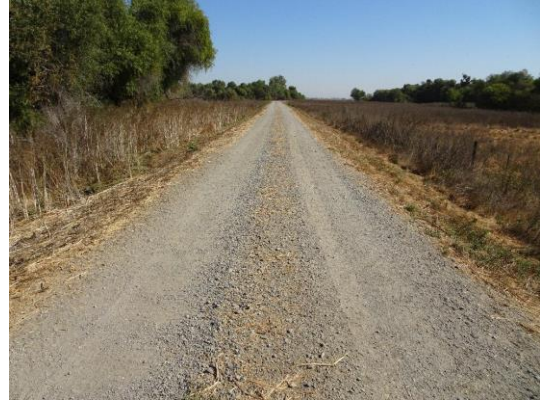
Photo 1 of 3 : UCIP_FA_2024_77851_90696.jpg

DS_ID:19612
FS_ID:77851
EP_NO: N/A
Repair Type: Urgent
EVAL Issue: 1, Pipe Integrity
Crossing Status: Found
UCIP Comments: 12/14/2022 Record updated from Non-Urgent to Urgent. DMP internal video inspection has found pipe integrity issues. LOF of crossing is between 5 and 6. Crossing will be monitored until funding becomes available to address the issues. (O.Yakimov - DWR UCIP)
10/20/2020 Record remains Non-Urgent. Scour is still present on both sides of the concrete LS headwall. Dense vegetation prevented updates on the scour progression along the LS slope. Recommend re-inspecting pipe when vegetation is removed. Unable to access to WS outlet due to wired fence. No permit was found authorizing this encroachment. CVFPB will need to review crossing to determine owner. DWR DMP internal inspection is pending and scheduled for 2021. (B. Singh - GEI, O. Magana - DWR UCIP)
10/08/2014 Dense vegetation limits the inspector's visibility to identify signs of pipe failure (leaks) along waterward and landward slopes. Recommend removing vegetation along pipe alignment to conduct proper inspection of structure and appurtenances. Pipe completely blocked by soil on LS toe due to animal activity. Slide gate blocked open. (W. Wylie - DWR UCIP)

FIELD_STRUCT_DESC: 48-inch corrugated metal (CM) gravity drainage pipe through the levee at an angle, 13.1 feet below the crown. Walkway to slide gate at the concrete headwall on the landside (LS) toe. Flap gate at the concrete headwall on the waterside (WS) toe. Brass cap No. 90 bench mark (BM) on the headwall on the LS.
[Additional Reference(s): DWR Levee Log, 2002, (HLM 6.13). USACE San Joaquin O&M Manual, Unit No. 601, Part No. 1, (SJR601.1), 1967, Revised 25 May 2011, (HLM 6.13)].
FS Date: 10/20/2020 1:32:39 PM

Overview of levee crown, looking US

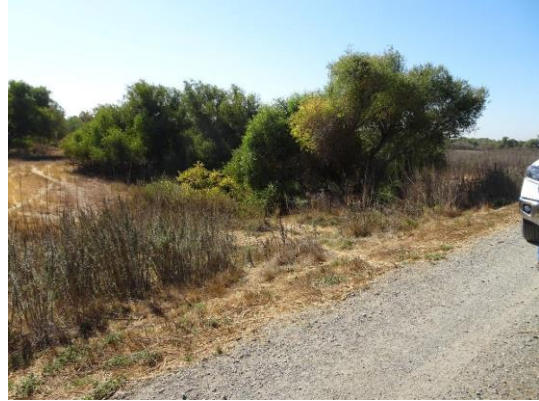
Photo 2 of 3 : UCIP_FA_2024_77851_90698.jpg

WS view: View of WS toe from levee crown. Headwall, pipe, and flapgate not visible from levee crown.

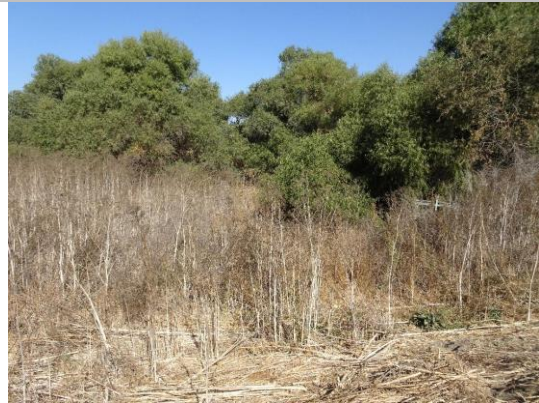
Photo 3 of 3 : UCIP_FA_2024_77851_90697.jpg

LS view: View toward LS toe. Slidegate visible through dense vegetation

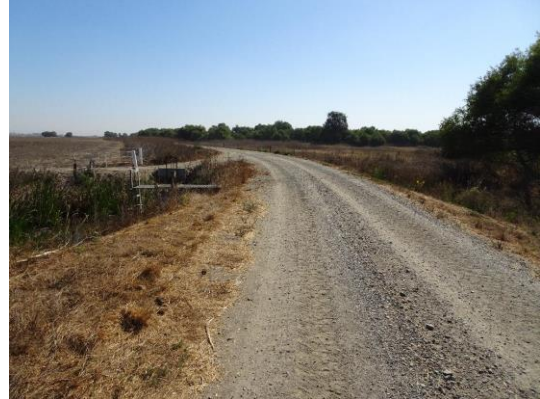
Photo 1 of 3 : UCIP_FA_2024_77852_90702.jpg

DS_ID:19613
FS_ID:77852
EP_NO: N/A
Repair Type: Urgent
EVAL Issue: 1, Pipe Integrity
Crossing Status: Found
UCIP Comments: 06/05/2024 Minor Alteration Work authorization No. WA2024094 issued for pipe replacement. Construction not yet started. (O. Yakimov - DWR UCIP)
12/14/2022 Record updated from Non-Urgent to Urgent. DMP internal video inspection has found pipe integrity issues. LOF of crossing is between 5 and 6. Crossing will be monitored until funding becomes available to address the issues. (O.Yakimov - DWR UCIP)
10/20/2020 Record remains Non-Urgent. Dense vegetation on WS toe, recommend removal for proper inspection. Minor surface erosion visible on the LS toe near the standpipe. No permit was found authorizing this encroachment. CVFPB will need to review crossing to determine owner. DWR DMP internal inspection is pending and scheduled for 2021. (B. Singh - GEI, O. Magana - DWR UCIP)
04/08/2014 Dense vegetation limits the inspector's visibility to identify signs of pipe failure (leaks) along the slope. Recommend removing vegetation along pipe alignment to conduct proper inspection of structure and appurtenances. (W. Wylie - DWR UCIP)

FIELD_STRUCT_DESC: 24-inch corrugated metal (CM) gravity drainage pipe through the levee, 9.5 feet below the crown. Flap gate on the waterside (WS) end. Slide gate on the landside (LS) end next to a 48-inch concrete riser unit with walkway over the top. Brass cap No. 90 bench mark (BM) on the headwall on the LS. [Additional Reference(s): DWR Levee Log, 2002, (HLM 6.44). USACE San Joaquin O&M Manual, Unit No. 601, Part No. 1, (SJR601.1), 1967, Revised 25 May 2011, (HLM 6.40)].
FS Date: 10/20/2020 1:35:41 PM

Overview of levee crown, looking upstream

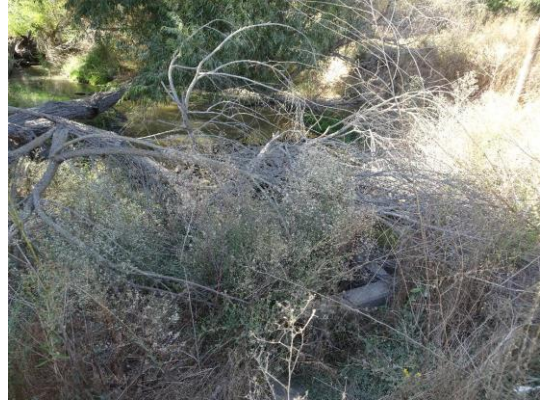
Photo 2 of 3 : UCIP_FA_2024_77852_90706.jpg

WS view: Inspection of WS headwall, pipe, and flapgate inhibited by dense vegetation

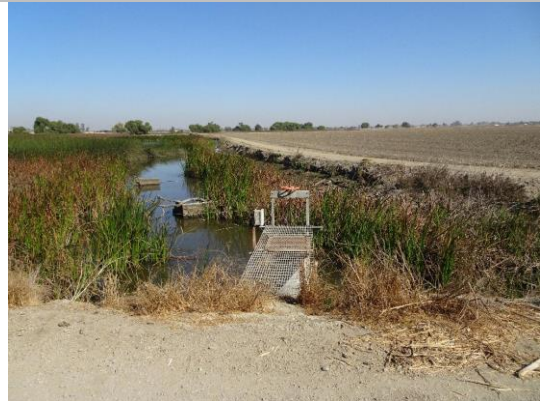
Photo 3 of 3 : UCIP_FA_2024_77852_90703.jpg

LS view: Metal walkway and slidegate visible on LS toe.

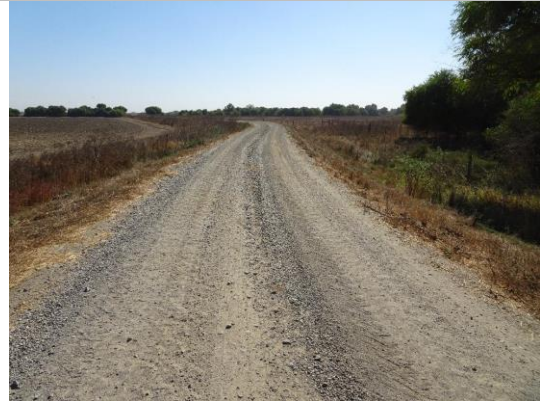
Photo 1 of 3 : UCIP_FA_2024_70663_90712.jpg

Comment Code					
Inspector Comment					
DS_ID:19614 FS_ID:70663 EP_NO: N/A Repair Type: Non-Urgent EVAL Issue: 5, Pipe Damage Crossing Status: Found UCIP Comments: 09/25/2024 DMP internal video inspection has found moderate pipe defects. Crossing will be monitored until funding becomes available for rehabilitation. (O. Yakimov - DWR UCIP) 10/20/2020 Record remains Non-Urgent. Dense vegetation inhibits inspection of the pipe on the LS toe, and both slopes. No permit was found authorizing this encroachment. CVFPB will need to review crossing to determine owner. DWR DMP internal inspection is pending and scheduled for 2021. (B. Singh - GEI, O. Magana - DWR UCIP) 7/19/2016 Same as previous inspection. Outlet and inlet are under water. (O. Magana - DWR UCIP) 4/08/2014 Flapgate blocked by sedimentation at WS toe. Dense vegetation limits the inspector's visibility to identify signs of pipe failure (leaks) along the slope. Recommend removing vegetation along pipe alignment to conduct proper inspection of structure and appurtenances. Also recommend clearing vegetation from both waterward and landward toe. (W. Wylie - DWR UCIP) FIELD_STRUCT_DESC: 24-inch corrugated metal (CM) gravity drainage pipe through the levee, 9.8 feet below the crown. Wooden fence around a 4-foot by 4-foot drop inlet on the landside (LS) toe. Flap gate on the waterside (WS) end. Brass cap No. 90 bench mark (BM) on the headwall on the LS. [Additional Reference(s): DWR Levee Log, 2002, (HLM 6.65). USACE San Joaquin O&M Manual, Unit No. 601, Part No. 1, (SJR601.1), 1967, Revised 25 May 2011, (HLM 6.64)]. FS Date: 10/20/2020

Overview of levee crown, looking US

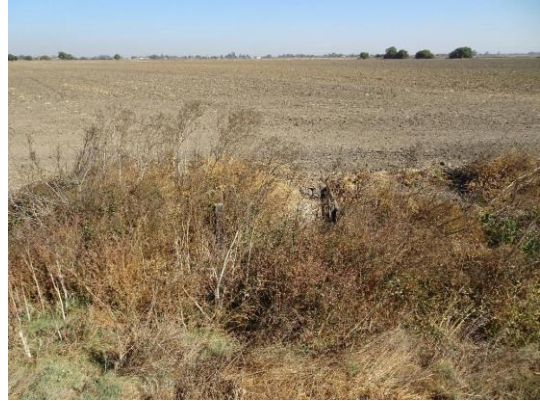
Photo 2 of 3 : UCIP_FA_2024_70663_90713.jpg

LS view: Dense vegetation on LS limiting view of wooden barrier around drop-inlet.

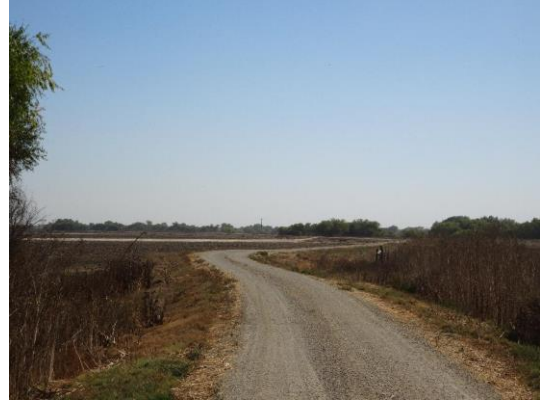
Photo 1 of 3 : UCIP_FA_2024_70664_90726.jpg

Overview of levee crown, looking US

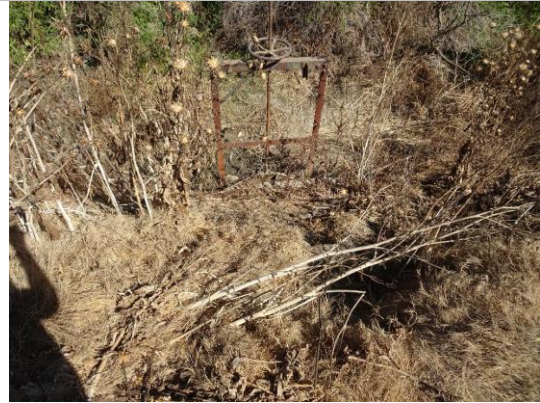
Photo 2 of 3 : UCIP_FA_2024_70664_90728.jpg

DS_ID:19615
FS_ID:70664
EP_NO: N/A
Repair Type: Urgent
EVAL Issue: 1, Pipe Integrity
Crossing Status: Found
UCIP Comments: 10/20/2020 Record has been updated from Non-Urgent to Urgent. Heavy corrosion present with visible holes found at the WS outlet near flap gate. Surface erosion present on the LS slope just upstream of slide gate. Evidence of surface erosion on the WS slope (vertical slope) was present approximately 15 feet downstream of the pipe. Plastic sheeting has been placed to prevent further erosion by LMA (assumed). Recommend notifying DWR Levee Inspector to monitor progress of surface erosion on the WS. No permit was found authorizing this encroachment. CVFPB will need to review crossing to determine owner. DWR DMP internal inspection is pending and scheduled for 2021. (B. Singh - GEI, O. Magana - DWR UCIP)
7/19/2016 Potential LS slope damage--difficult to determine due to dense vegetation. Limited access on WS toe due to wire fence. (O. Magana - DWR UCIP)

LS view: Surface erosion above LS headwall

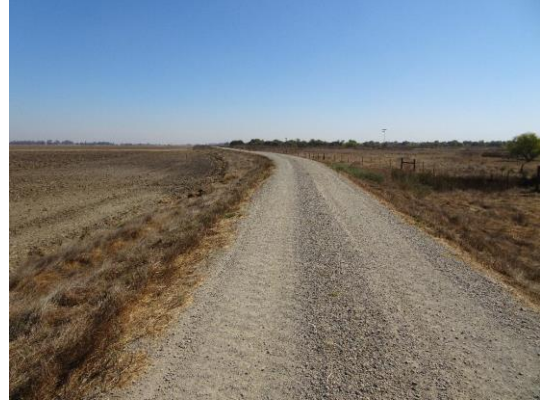
Photo 1 of 3 : UCIP_FA_2024_70665_90715.jpg

Overview of levee crown, looking US

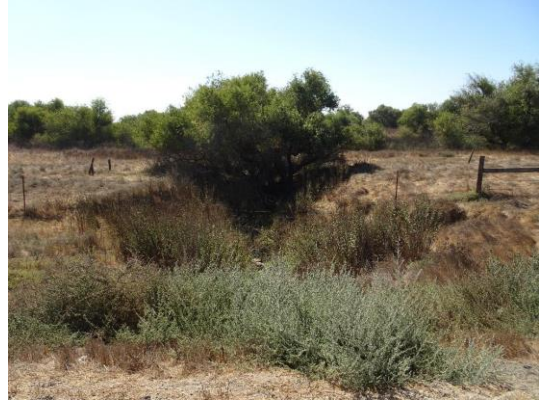
Photo 2 of 3 : UCIP_FA_2024_70665_90717.jpg

Comment Code					
Inspector Comment					
DS_ID:19616 FS_ID:70665 EP_NO: N/A Repair Type: Urgent EVAL Issue: 1, Pipe Integrity Crossing Status: Found UCIP Comments: 10/20/2020 Record remains Urgent. DWR DMP has found integrity issues, LOF between 5 and 6. Pipe deeply corroded. Crossing will be monitored until funding becomes available to address. No permit was found authorizing this encroachment. CVFPB will need to review crossing to determine owner. (B. Singh - GEI, O. Magana - DWR UCIP) 1/01/2018 Pipe continues to corrode through. Voids (undermining) along pipe invert are visible from the LS. Potential undermining caused by erosion under concrete apron on the WS. Crossing remains Urgent due to the pipe failure. (O. Magana - DWR UCIP) 4/08/2014 Pipe failing and corroded through at LS toe. Need to contact owner to determine status of crossing. Also dense vegetation limits the inspector's visibility to identify signs of pipe failure (leaks) along the landward slope. Recommend removing vegetation along pipe alignment to conduct proper inspection of structure. (W. Wylie - DWR UCIP) FIELD_STRUCT_DESC: 24-inch corrugated metal (CM) gravity drainage pipe through the levee, 5.1 feet below the crown. Flap gate on the waterside (WS) end. Brass cap No. 90 bench mark (BM) on the headwall on the landside (LS). [Additional Reference(s): DWR Levee Log, 2002, (HLM 7.22). USACE San Joaquin O&M Manual, Unit No. 601, Part No. 1, (SJR601.1), 1967, Revised 25 May 2011, (HLM 7.21)]. FS Date: 10/20/2020

WS view: Pipe and flapgate at WS toe not visible from levee crown due to vegetation.

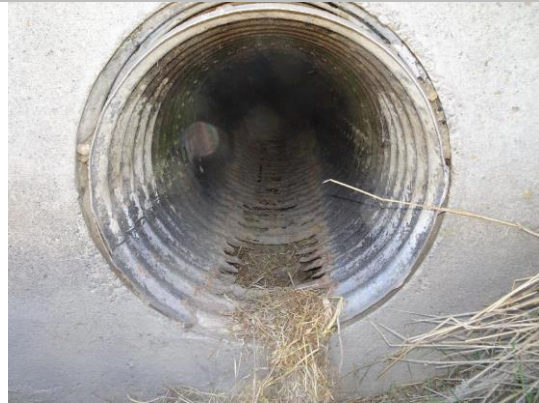
Photo 3 of 3 : UCIP_FA_2024_70665_90720.jpg

LS view: Headwall and deeply corroded pipe at LS toe

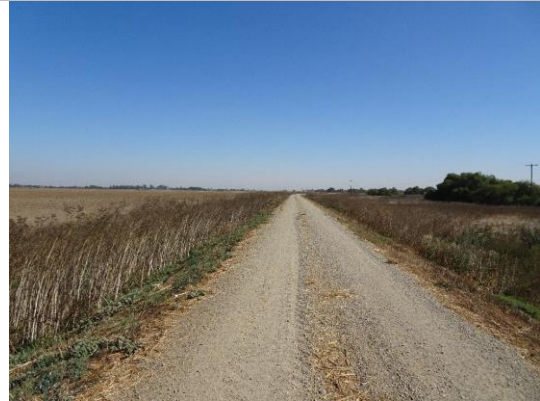
Photo 1 of 3 : UCIP_FA_2024_83244_90738.jpg

Overview of levee crown, looking US

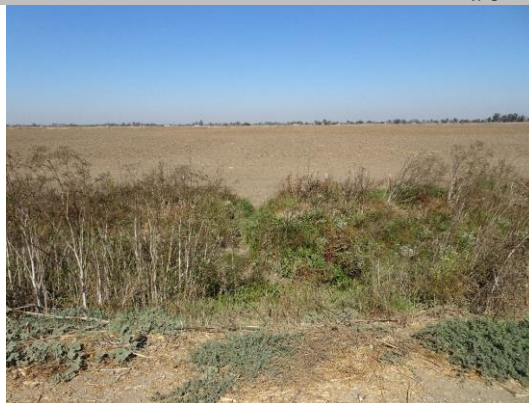
Photo 2 of 3 : UCIP_FA_2024_83244_90739.jpg

LS view: Headwall not visible at LS toe from levee crown due to vegetation

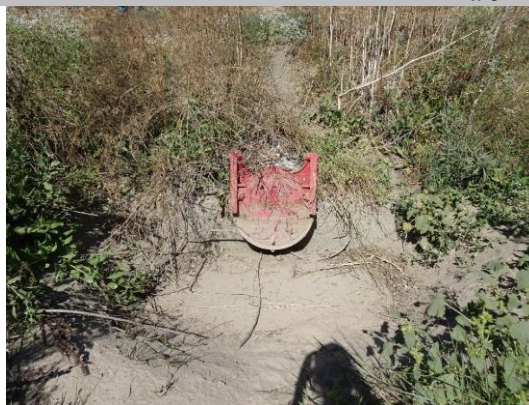
Photo 3 of 3 : UCIP_FA_2024_83244_90736.jpg

Comment Code						
Inspector Comment						
DS_ID:19618 FS_ID:83244 EP_NO: N/A Repair Type: Non-Urgent EVAL Issue: Crossing Status: Found UCIP Comments: 12/20/2022 Record updated from Urgent to Non-Urgent. Pipe has been CIPP-lined. LOF of crossing is less or equal to 4. Recommend next video inspection in 5 years. (O.Yakimov - DWR UCIP) 10/20/2020 Record has been updated from Non-Urgent to Urgent. DWR DMP has found integrity issues, LOF between 5 and 6. Crossing will be monitored until funding becomes available to address. Topography of WS toe has changed over time with sediment build-up preventing proper drainage. At the pipe outlet there is a gradual ground elevation change that causes the water to pond against the flap gate. No permit was found authorizing this encroachment. CVFPB will need to review crossing to determine owner. (B. Singh - GEI, O. Magana - DWR UCIP) 04/08/2014 Dense vegetation limits the inspector's visibility to identify signs of pipe failure (leaks) along the slope. Recommend removing vegetation along pipe alignment to conduct proper inspection of structure and appurtenances. (W. Wylie - DWR UCIP) FIELD_STRUCT_DESC: 24-inch CIPP-lined corrugated metal (CM) gravity drainage pipe through the levee, 8.0 feet below the crown. Flap gate on the waterside (WS) end. Brass cap No. 80 bench mark (BM) on the headwall on the landside (LS). [Additional Reference(s): DWR Levee Log, 2002, (HLM 7.46). USACE San Joaquin O&M Manual, Unit No. 601, Part No. 1, (SJR601.1), 1967, Revised 25 May 2011, (HLM 7.46)]. FS Date: 10/20/2020 8:52:25 AM

WS view: Pipe, flapgate and headwall at WS toe. Flapgate damaged and non-functional

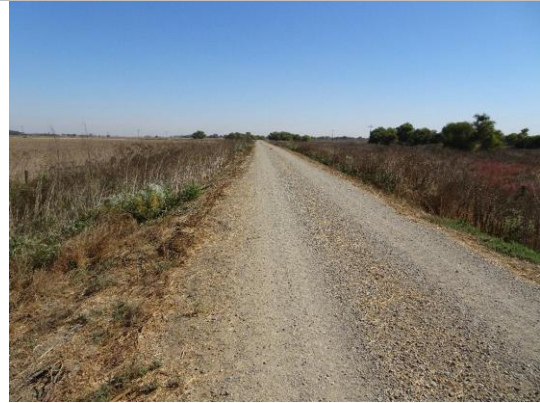
Photo 1 of 3 : UCIP_FA_2024_84498_90744.jpg

Overview of levee crown, looking US

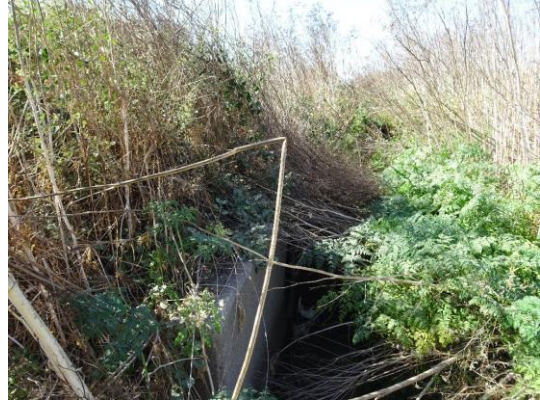
Photo 2 of 3 : UCIP_FA_2024_84498_90747.jpg

LS view: Headwall at LS toe. Dense vegetation blocking view

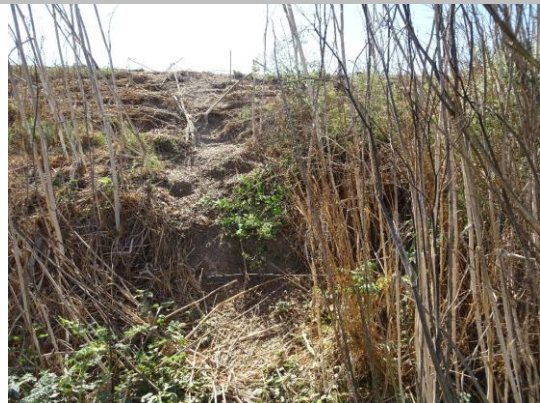
Photo 3 of 3 : UCIP_FA_2024_84498_90749.jpg

Comment Code						
Inspector Comment						
DS_ID:19619 FS_ID:84498 EP_NO: N/A Repair Type: No Action Needed EVAL Issue: Crossing Status: Found UCIP Comments: 07/11/2024 Record has been updated from Urgent to No Action Needed. Sloughing on the LS slope above headwall has been addressed. (M. Thao - DWR UCIP)02/20/2022 Record remains Urgent. Pipe has been CIPP-lined. LOF of crossing is less or equal to 4. Recommend next video inspection in 5 years. Sloughing on the LS slope above headwall needs to be addressed. (O. Yakimov - DWR UCIP)0/20/2020 Record has been updated from Non-Urgent to Urgent. Sloughing observed on the LS slope above headwall. DWR DMP has found integrity issues, LOF between 5 and 6. Crossing will be monitored until funding becomes available to address. No permit was found authorizing this encroachment. CVFPB will need to review crossing to determine owner. (B. Singh - GEI, O. Magana - DWR UCIP)04/08/2014 Dense vegetation limits the inspector's visibility to identify signs of pipe failure (leaks) along the slope. Recommend removing vegetation along pipe alignment to conduct proper inspection of structure. (W. Wylie - DWR UCIP) FIELD_STRUCT_DESC: 24-inch CIPP-lined corrugated metal (CM) gravity drainage pipe through the levee, 10.0 feet below the crown. Flap gate on the waterside (WS) end. Brass cap No. 80 bench mark (BM) on the headwall on the landside (LS). [Additional Reference(s): DWR Levee Log, 2002, (HLM 7.70). USACE San Joaquin O&M Manual, Unit No. 601, Part No. 1, (SJR601.1), 1967, Revised 25 May 2011, (HLM 7.69)]. FS Date: 10/20/2020

LS view: Sloughing above headwall and pipe on LS slope

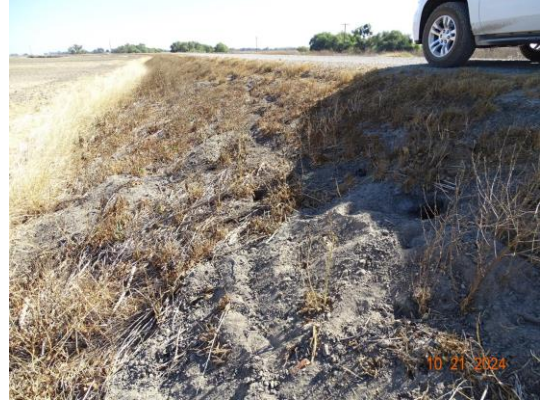
Photo 1 of 1 : FA_2024_NA0010_118_125_20241105_00254.jpg

LM Start	7.69	Rating **	M	Issue No.	125
LM End	7.69	Issue Type +	Ma	Location *	LS
Category	Earthen Levee			GPS Latitude/Longitude	
				Start	End
Item	Animal Control			37.299051 °	37.299051 °
				-120.873720 °	-120.873720 °
DWR ID	DWR_NA0010_01_f _ 2023_125				
Comment Code					
A3 : No rodents visible, but rodent burrows visible; need to backfill and compact or grout burrows.					
Inspector Comment

View of rodent holes in the landside slope. (Fall 2024)

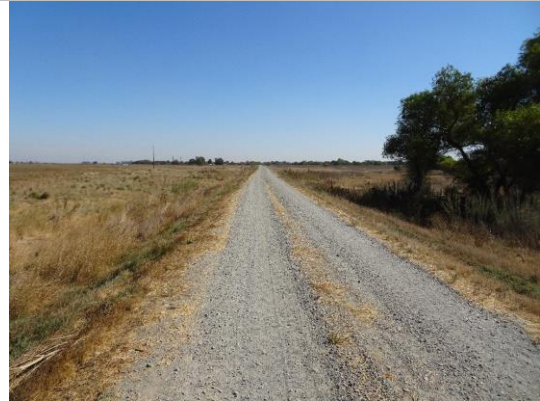
Photo 1 of 3 : UCIP_FA_2024_70669_90750.jpg

Overview of levee crown, looking US

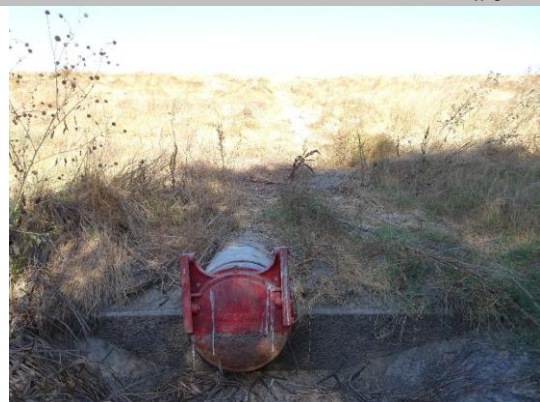
Photo 2 of 3 : UCIP_FA_2024_70669_90755.jpg

Pipe, flapgate, and headwall at WS toe

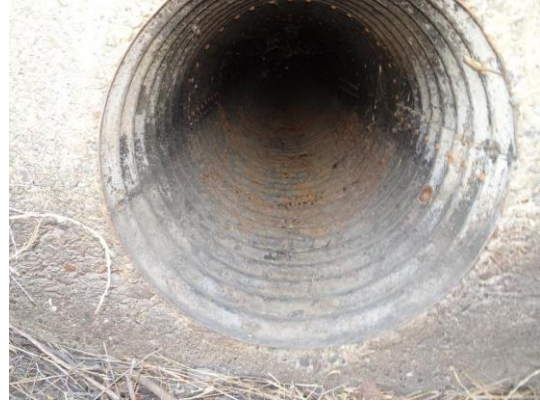
Photo 3 of 3 : UCIP_FA_2024_70669_90753.jpg

DS_ID:19620
FS_ID:70669
EP_NO: N/A
Repair Type: No Action Needed
EVAL Issue:
Crossing Status: Found
UCIP Comments: 09/15/2023 Record updated from Non-Urgent to No Action Needed. Pipe was CIPP lined. DMP internal video inspection has found none or minor pipe defects. Recommend next video inspection in 5 years. (O. Yakimov - DWR UCIP)
10/20/2020 Record remains Non-Urgent. DWR DMP has found integrity issues, LOF between 4 and 5. Corrosion in pipe visible on the LS toe. Crossing will be monitored until funding becomes available for rehabilitation. No permit was found authorizing this encroachment. CVFPB will need to review crossing to determine owner. (B. Singh - GEI, O. Magana - DWR UCIP)
04/09/2014 Dense vegetation limits the inspector's visibility to identify signs of pipe failure (leaks) along the slope. Recommend removing vegetation along pipe alignment to conduct proper inspection of structure. (W. Wylie - DWR UCIP)

Headwall and pipe at LS toe. Visible corrosion in pipe.

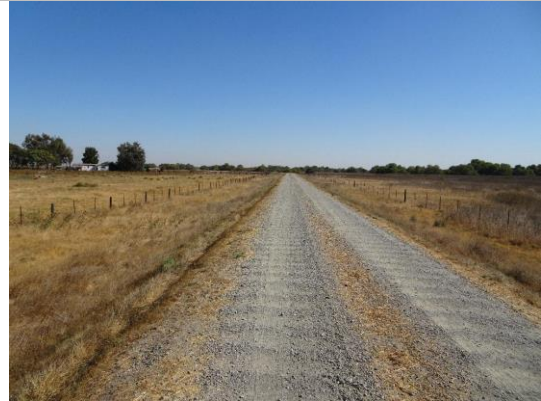
Photo 1 of 3 : UCIP_FA_2024_70670_90757.jpg

Overview of levee crown, looking US

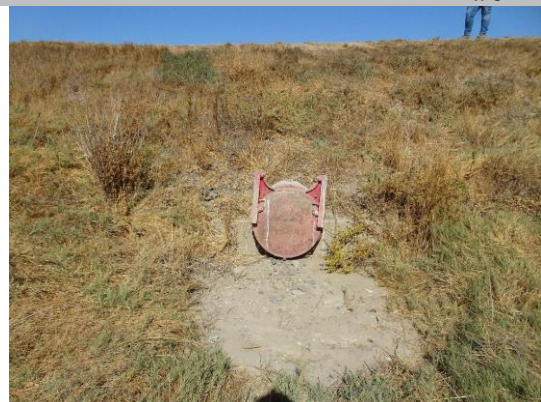
Photo 2 of 3 : UCIP_FA_2024_70670_90756.jpg

WS view: Pipe, flapgate, and headwall at WS toe

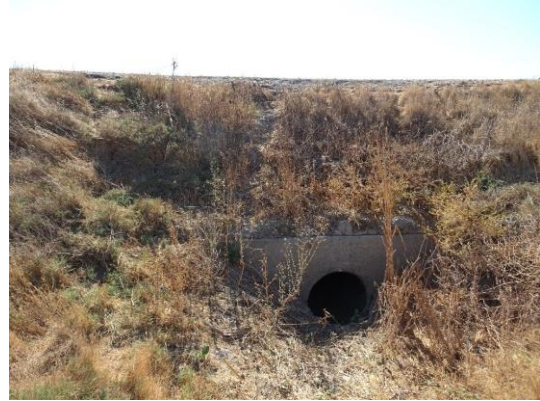
Photo 3 of 3 : UCIP_FA_2024_70670_90762.jpg

DS_ID:19621
FS_ID:70670
EP_NO: N/A
Repair Type: No Action Needed
EVAL Issue:
Crossing Status: Found
UCIP Comments: 09/15/2023 Record updated from Non-Urgent to No Action Needed. Pipe was CIPP lined. DMP internal video inspection has found none or minor pipe defects. Recommend next video inspection in 5 years. (O. Yakimov - DWR UCIP)
10/20/2020 Record remains Non-Urgent. DWR DMP has found integrity issues, LOF between 4 and 5. Crossing will be monitored until funding becomes available for rehabilitation. No permit was found authorizing this encroachment. CVFPB will need to review crossing to determine owner. (B. Singh - GEI, O. Magana - DWR UCIP)
04/09/2014 Dense vegetation limits the inspector's visibility to identify signs of pipe failure (leaks) along the slope. Recommend removing vegetation along pipe alignment to conduct proper inspection of structure. Sediment buildup at landward toe. (W. Wylie - DWR UCIP)

LS view: Pipe, headwall, and slope from LS toe

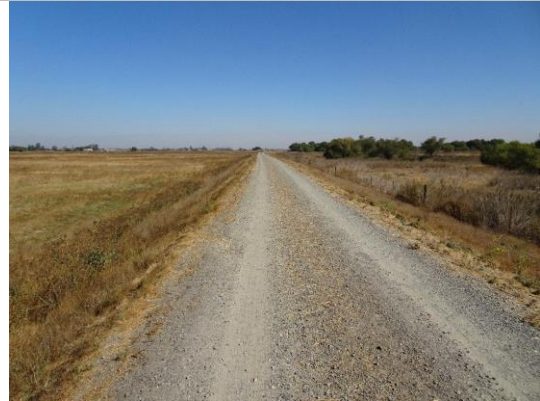
Photo 1 of 3 : UCIP_FA_2024_70672_90770.jpg

Overview of levee crown, looking US

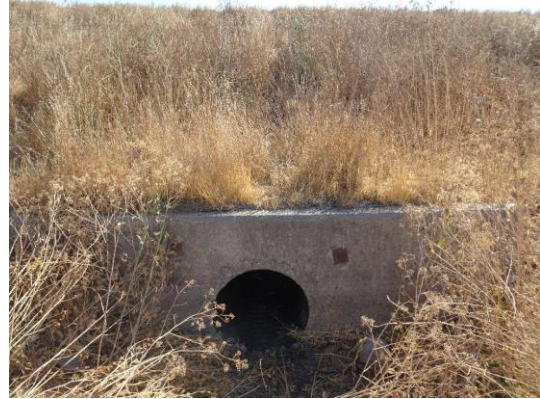
Photo 3 of 3 : UCIP_FA_2024_70672_90773.jpg

DS_ID:19622
FS_ID:70672
EP_NO: N/A
Repair Type: Non-Urgent
EVAL Issue:
Crossing Status: Found
UCIP Comments: 10/20/2020 Record has been updated from No Action Needed to Non-Urgent. Large burrow hole observed approximately 100 feet downstream of the pipe, on LS shoulder of the levee crown. No permit was found authorizing this encroachment. CVFPB will need to review crossing to determine owner. DWR DMP has not found internal issues, LOF between 1 and 2. Recommend inspection in 5 years. (B. Singh - GEI, O. Magana - DWR UCIP)
FIELD_STRUCT_DESC: 24-inch corrugated metal (CM) gravity drainage pipe through the levee, 9.0 feet below the crown. Flap gate on the waterside (WS) end. Brass cap No. 80 bench mark (BM) on the headwall on the landside (LS). [Additional Reference(s): DWR Levee Log, 2002, (HLM 8.62). USACE San Joaquin O&M Manual, Unit No. 601, Part No. 1, (SJR601.1), 1967, Revised 25 May 2011, (HLM 8.61)].

LS view: Pipe and headwall on LS toe

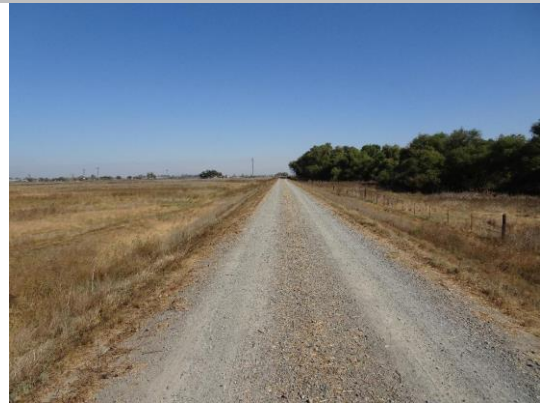
Photo 1 of 3 : UCIP_FA_2024_83245_90778.jpg

Overview of levee crown, looking US

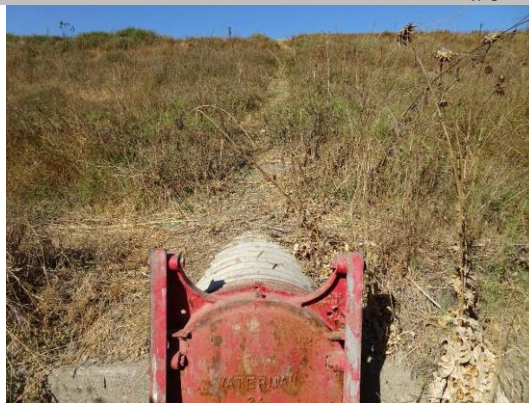
Photo 2 of 3 : UCIP_FA_2024_83245_90777.jpg

WS view: Pipe, flapgate, headwall, and slope at WS toe

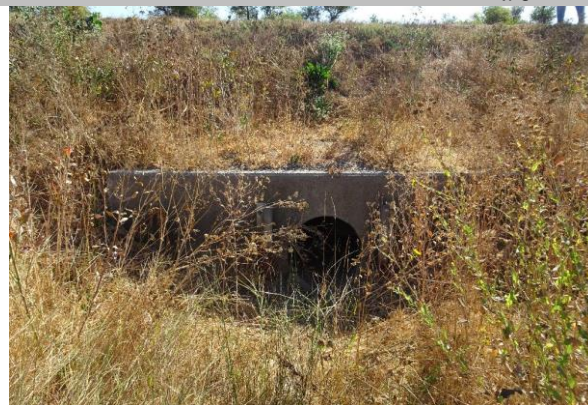
Photo 3 of 3 : UCIP_FA_2024_83245_90781.jpg

DS_ID:19623
FS_ID:83245
EP_NO: N/A
Repair Type: No Action Needed
EVAL Issue:
Crossing Status: Found
UCIP Comments: 04/23/2024 Record updated from Non-Urgent to No Action Needed. DMP internal video inspection has found none or minor pipe defects. (M. Thao - DWR UCIP)
10/20/2020 Record remains Non-Urgent. No permit was found authorizing this encroachment. CVFPB will need to review crossing to determine owner. DWR DMP has not found internal issues, LOF between 1 and 2. Recommend inspection in 5 years. (B. Singh - GEI, O. Magana - DWR UCIP)
04/09/2014 Dense vegetation limits the inspector's visibility to identify signs of pipe failure (leaks) along the slope. Recommend removing vegetation along pipe alignment to conduct proper inspection of structure. (W. Wylie - DWR UCIP)
FIELD_STRUCT_DESC: 24-inch corrugated metal (CM) gravity drainage pipe through the levee, 9.1 feet below the crown. Flap gate on the waterside (WS) end. Brass cap No. 80 bench mark (BM) on the headwall on the landside (LS). [Additional Reference(s): DWR Levee Log, 2002, (HLM 8.95). USACE San Joaquin O&M, Unit No. 601, Part No. 1, (SJR601.1), 1967, Revised 25 May 2011, (HLM 8.93)].

LS view: Pipe, headwall, and slope at LS toe

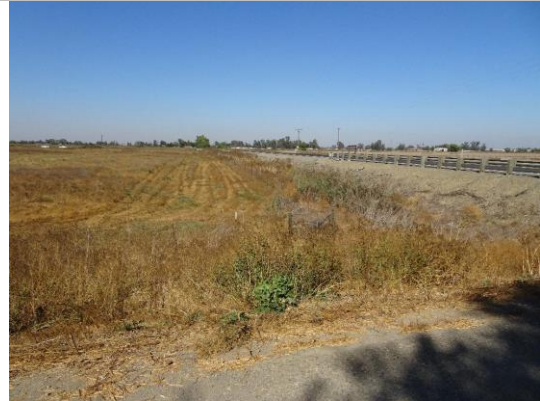
Photo 1 of 3 : UCIP_FA_2024_83428_90783.jpg

DS_ID:19624
FS_ID:83428
EP_NO: 12156
Repair Type: Urgent
EVAL Issue: 3a, Flood Risk
Crossing Status: Found
UCIP Comments: 05/28/2024 Notice to Comply Case No. 2024-15411 issued to this crossing for a heavily corroded slide gate resulting in an inability to close the pipe against floodwaters. (O. Yakimov - DWR UCIP)
10/20/2020 Record remains Urgent. There is no operating gate that will prevent flows from the WS to LS. Dense vegetation prevented a full inspection of this crossing. Need to contact owner to clear the dense vegetation on both the WS and the LS to be able to perform proper inspection of crossing. DWR DMP has completed a geophysical study in this area and plans to complete an internal inspection of this pipe. The pipe is scheduled for an internal inspection in 2021. (B. Singh - GEI, O. Magana - DWR UCIP)
01/01/2018 Dense vegetation prevented a full inspection of this crossing. Assumed crossing remains the same as the 2016 inspection. Crossing remains Urgent due to signs of pipe being rusted through visible from the WS. Need to contact owner to clear the dense vegetation on both the WS and the LS to be able to perform proper inspection of crossing. (O. Magana - DWR UCIP)

07/19/2016 same as previous inspection--pipe rusted through. Sediment visible inside LS pipe; walkway wood panels have dry rot and appears to be unsafe to use. (O. Magana - DWR UCIP)
04/09/2014 Slide gate rusted through and open on WS toe. Inlet appears to be obscured or covered in soil at LS toe. Also dense vegetation on waterward and landward sides. Need to contact owner to contact CVFPB to address issue. (W. Wylie - DWR UCIP)
FIELD_STRUCT_DESC: 30-inch reinforced concrete (RC) gravity drainage pipe containing a 26-inch steel pipe through the levee, 7.3 feet below the crown. Annular space grouted. Two concrete cutoff walls in the center of the levee. Slide gate with elevated walkway access on the waterside (WS) end. 6-inch-thick concrete headwall on the WS end. Concrete wing walls on each end. (30-inch drainage pipe with a valve authorized under Permit No. 12156, 1977 - Merquin County Water District. Additional Related Permit(s): Permit No. 12156-A, 1978 - Merquin County Water District). [Additional Reference(s): DWR Levee Log, 2002, (HLM 9.01)].

LS view: View of LS toe from levee crown

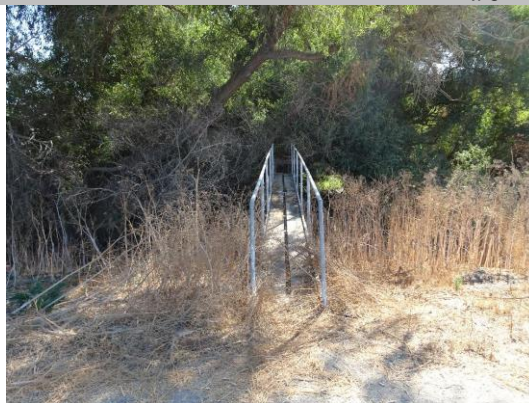
Photo 2 of 3 : UCIP_FA_2024_83428_90784.jpg

WS view: View toward WS toe

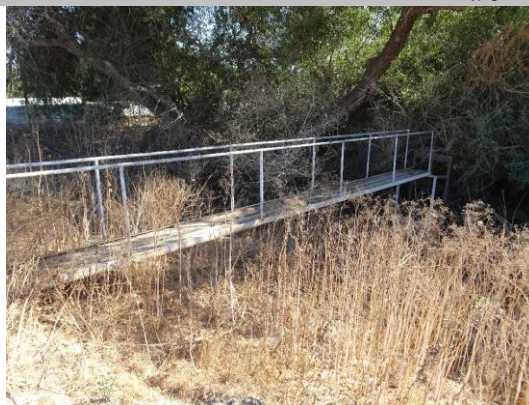
Photo 3 of 3 : UCIP_FA_2024_83428_90786.jpg

WS view: Elevated walkway across WS slope

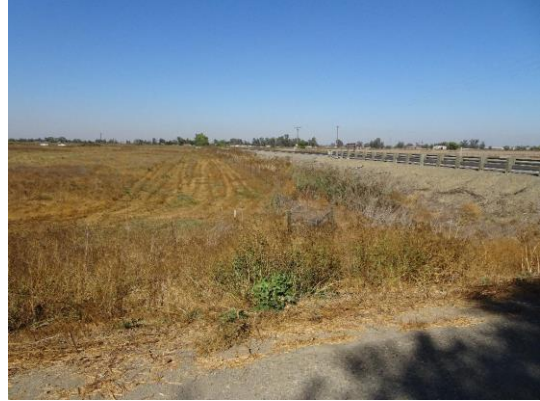
Photo 1 of 3 : UCIP_FA_2024_84500_90789.jpg

Comment Code					
Inspector Comment					
DS_ID:19625 FS_ID:84500 EP_NO: N/A Repair Type: Non-Urgent EVAL Issue: Crossing Status: Found UCIP Comments: 10/20/2020 Record remains Non-Urgent. As in previous inspection, dense vegetation inhibited proper inspection of the pipe and slope. No permit was found authorizing this encroachment. CVFPB will need to review crossing to determine owner. DWR DMP internal inspection is pending and scheduled for 2021. (B. Singh - GEI, O. Magana - DWR UCIP) 10/09/2014 Dense vegetation limits the inspector's visibility to identify signs of pipe failure (leaks) along the slope. Recommend removing vegetation along pipe alignment to conduct proper inspection of structure. Some sediment buildup in pipe. (W. Wylie - DWR UCIP) FIELD_STRUCT_DESC: 36-inch corrugated metal (CM) gravity drainage pipe through the levee, 10.0 feet below the crown. Flap gate on the waterside (WS) end. Brass cap No. 80 bench mark (BM) on the headwall on the landside (LS). [Additional Reference(s): DWR Levee Log, 2002, (HLM 9.01). USACE San Joaquin O&M Manual, Unit No. 601, Part No. 1, (SJR601.1), 1967, Revised 25 May 2011, (HLM 9.00)]. FS Date: 10/20/2020

LS view: View toward LS toe. Headwall not visible due to high vegetation.

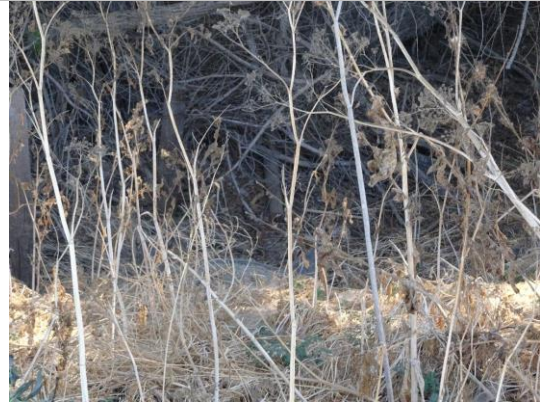
Photo 3 of 3 : UCIP_FA_2024_84500_92420.jpg

WS view: pipe visible through dense vegetation.

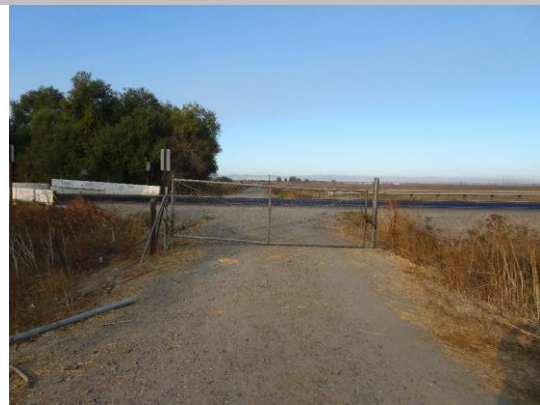
Photo 1 of 3 : UCIP_FA_2024_70676_90906.jpg

DS_ID:19626
FS_ID:70676
EP_NO: N/A
Repair Type: Non-Urgent
EVAL Issue: 5, Pipe Damage
Crossing Status: Found
UCIP Comments: 09/25/2024 DMP internal video inspection has found moderate pipe defects. Crossing will be monitored until funding becomes available for rehabilitation. (O. Yakimov - DWR UCIP)
10/21/2020 Record remains Non-Urgent. Dense vegetation inhibited proper inspection of pipe condition. No permit was found authorizing this encroachment. CVFPB will need to review crossing to determine owner. DWR DMP internal inspection is pending and scheduled for 2021. (B. Singh - GEI, O. Magana - DWR UCIP)
04/09/2014 Dense vegetation limits the inspector's visibility to identify signs of pipe failure (leaks) along the slope. Recommend removing vegetation along pipe alignment to conduct proper inspection of structure. (W. Wylie - DWR UCIP)
FIELD_STRUCT_DESC: 24-inch corrugated metal (CM) gravity drainage pipe through the levee, 10.0 feet below the crown. Flap gate on the waterside (WS) end. Brass cap No. 80 bench mark (BM) on the headwall on the landside (LS). [Additional Reference(s): DWR Levee Log, 2002, (HLM 9.03). USACE San Joaquin O&M Manual, Unit No. 601, Part No. 1, (SJR601.1), 1967, Revised 25 May 2011, (HLM 9.03)].

Overview of levee crown looking downstream.

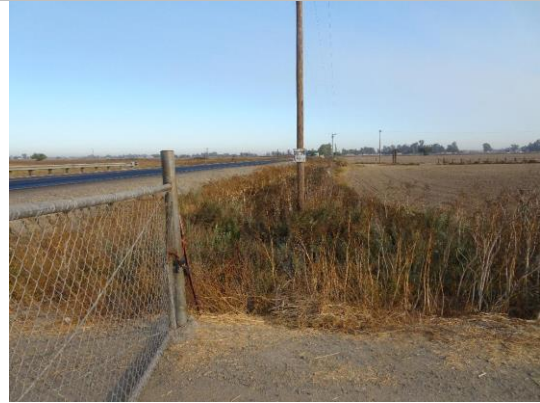
Photo 2 of 3 : UCIP_FA_2024_70676_90907.jpg

LS view: overview of LS

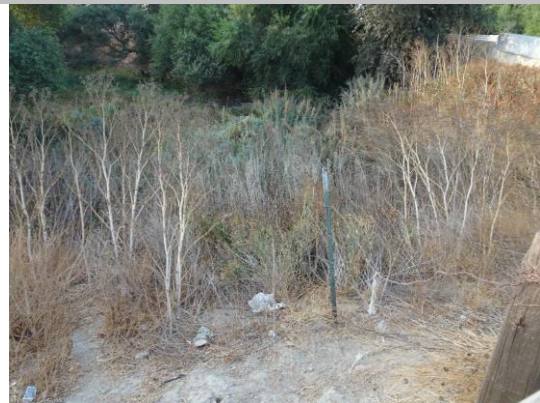
Photo 3 of 3 : UCIP_FA_2024_70676_90909.jpg

WS view: overview of WS

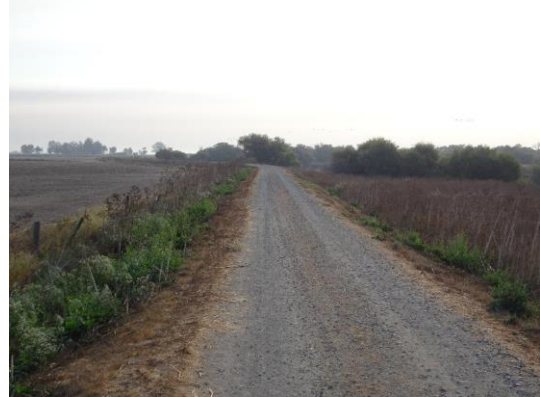
Photo 1 of 3 : UCIP_FA_2024_83466_90910.jpg

Comment Code					
Inspector Comment					
DS_ID:19627 FS_ID:83466 EP_NO: N/A Repair Type: Non-Urgent EVAL Issue: 6, Levee Damage or Threat for Levee Damage Crossing Status: Found UCIP Comments: 12/20/2022 Record updated from Urgent to Non-Urgent. Pipe has been CIPP-lined. LOF of crossing is less or equal to 4. Recommend next video inspection in 5 years. (O.Yakimov - DWR UCIP) 10/21/2020 Record has been updated from Non-Urgent to Urgent. DWR DMP has found integrity issues, LOF between 5 and 6. Scouring observed about 2 feet downstream of pipe at WS toe. Crossing will be monitored until funding becomes available to address. No permit was found authorizing this encroachment. CVFPB will need to review crossing to determine owner. (B. Singh - GEI, O. Magana - DWR UCIP) 10/09/2014 Dense vegetation limits the inspector's visibility to identify signs of pipe failure (leaks) along the slope. Recommend removing vegetation along pipe alignment to conduct proper inspection of structure. (W. Wylie - DWR UCIP) FIELD_STRUCT_DESC: 24-inch CIPP-lined corrugated metal (CM) gravity drainage pipe through the levee, 8.6 feet below the crown. Concrete drop inlet at the landside (LS) toe. Flap gate on the waterside (WS) end. Brass cap No. 80 bench mark (BM) on the headwall on the LS. [Additional Reference(s): DWR Levee Log, 2002, (HLM 9.39). USACE San Joaquin O&M Manual, Unit No. 601, Part No. 1, (SJR601.1), 1967, Revised 25 May 2011, (HLM 9.37)]. FS Date: 10/21/2020 8:59:04 AM

Overview of levee crown

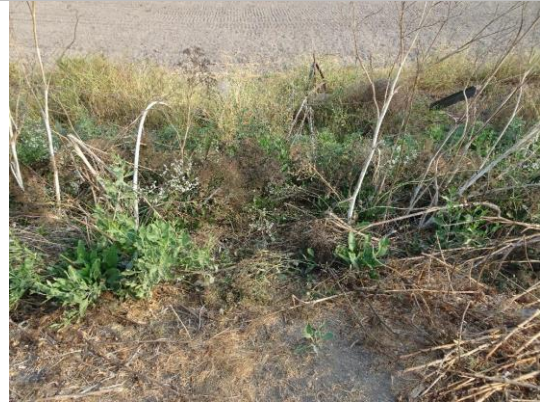
Photo 2 of 3 : UCIP_FA_2024_83466_90911.jpg

LS view: View of LS slope from levee crown

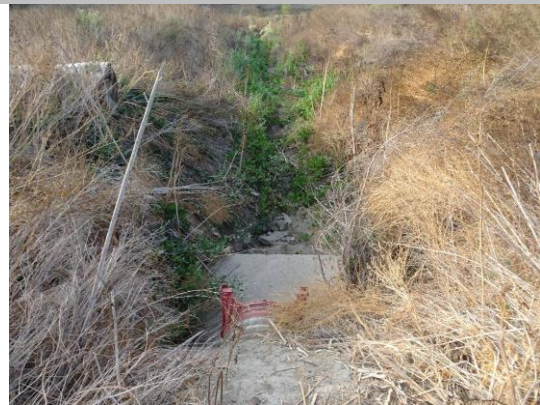
Photo 3 of 3 : UCIP_FA_2024_83466_90914.jpg

WS view: Pipe and flapgate at WS toe

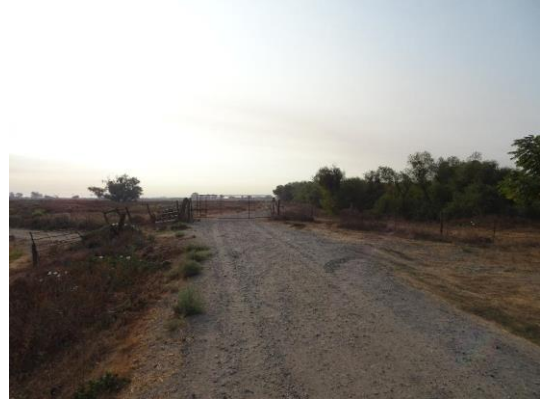
Photo 1 of 3 : UCIP_FA_2024_70678_90915.jpg

Comment Code						
Inspector Comment						
DS_ID:19628 FS_ID:70678 EP_NO: N/A Repair Type: Non-Urgent EVAL Issue: Crossing Status: Found UCIP Comments: 10/21/2020 Record has been updated from No Action Needed to Non-Urgent. No permit was found authorizing this encroachment. CVFPB will need to review crossing to determine owner. DWR DMP has not found internal issues, LOF between 1 and 2. Recommend inspection in 5 years. (B. Singh - GEI, O. Magana - DWR UCIP) FIELD_STRUCT_DESC: 24-inch corrugated metal (CM) gravity drainage pipe through the levee, 4.5 feet below the crown. Flap gate on the waterside (WS) end. Brass cap No. 80 bench mark (BM) on the headwall on the landside (LS). [Additional Reference(s): DWR Levee Log, 2002, (HLM 9.68). USACE San Joaquin O&M Manual, Unit No. 601, Part No. 1, (SJR601.1), 1967, Revised 25 May 2011, (HLM 9.67)]. FS Date: 10/21/2020

Overview of levee crown

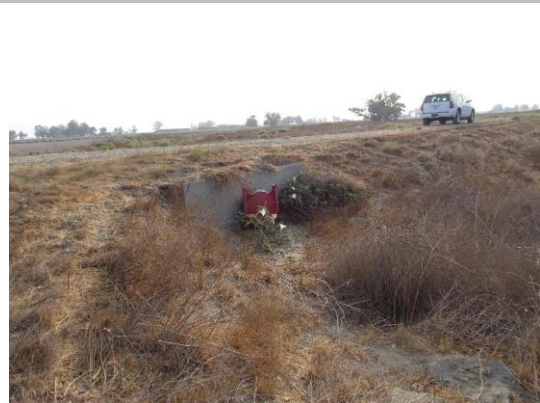
Photo 2 of 3 : UCIP_FA_2024_70678_90917.jpg

WS view: Pipe, flapgate, and headwall at WS toe

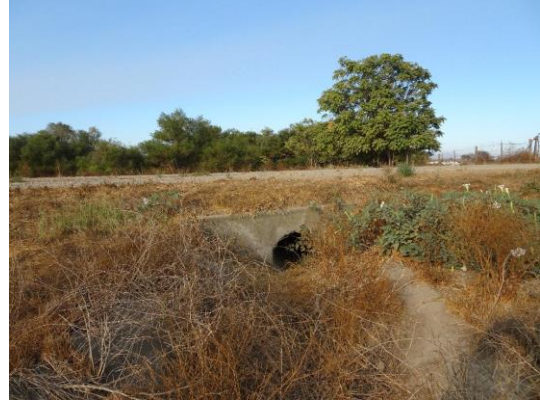
Photo 3 of 3 : UCIP_FA_2024_70678_90920.jpg

LS view: Pipe and headwall at LS toe

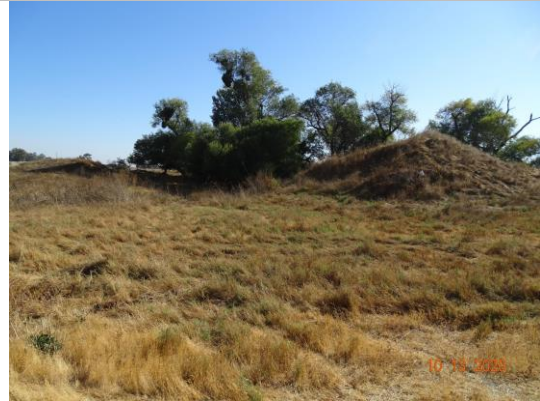
Photo 1 of 1 : FA_2024_NA0010_118_112_20240828_00013.jpg

LM Start	9.89	Rating **	A/W	Issue No.	112
LM End	9.90	Issue Type +	Ma	Location *	CR
Category	Earthen Levee			GPS Latitude/Longitude	
				Start	End
Item	Crown Surface / Depressions / Rutting			37.291796 °	37.291581 °
				-120.839497 °	-120.839718 °
DWR ID	DWR_NA0010_01_f_2017_112				
Comment Code					
C1 : Add appropriate material and re-grade the levee to bring the crown above the design elevation.					
Inspector Comment					
Landowner degraded levee in the 1970's because water on LS was flooding his property. Landowner has prevented efforts to restore levee. LMA has stated that no water from the waterside of the levee has ever backed up through the degraded levee and caused flooding.

Looking east at the levee breach. (Fall 2020)

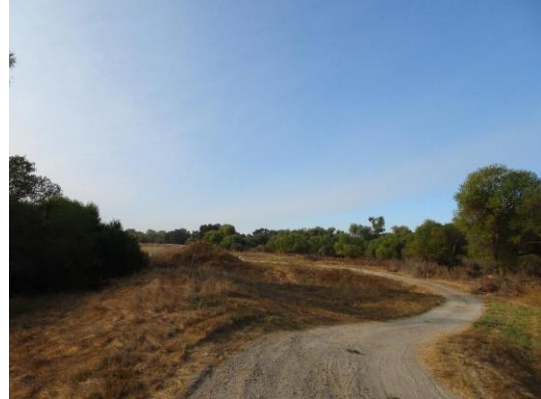
Photo 1 of 3 : UCIP_FA_2024_70680_91045.jpg

Comment Code					
Inspector Comment					
DS_ID:19556 FS_ID:70680 EP_NO: N/A Repair Type: Non-Urgent EVAL Issue: Crossing Status: Indicator Found UCIP Comments: 10/21/2020 Record has been updated from No Action Needed to Non-Urgent. No levee present at this location. This crossing was identified as a System Feature. Pipe not found by visual inspection, only two culverts at grade in the WS. (B. Singh - GEI, O. Magana - DWR UCIP) FIELD_STRUCT_DESC: 24-inch corrugated metal (CM) gravity drainage pipe through the levee, 6.0 feet below the crown. Flap gate on the waterside (WS) end. Brass cap No. 70 bench mark (BM) on the headwall on the landside (LS). [Additional Reference(s): DWR Levee Log, 2002, (HLM 9.91). USACE San Joaquin O&M Manual, Unit No. 601, Part No. 1, (SJR601.1), 1967, Revised 25 May 2011, (HLM 9.93)]. FS Date: 10/21/2020

Overview of area looking upstream at levee breach.

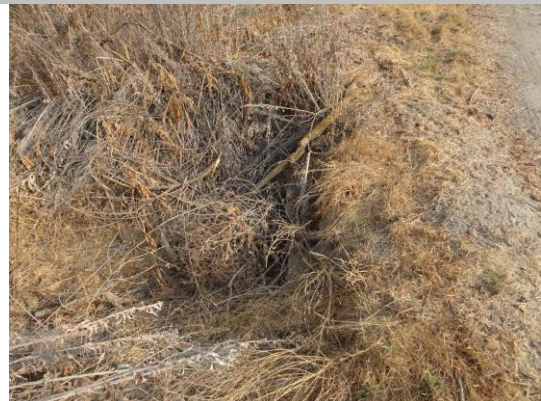
Photo 2 of 3 : UCIP_FA_2024_70680_91047.jpg

Culverts underneath access road visible on WS

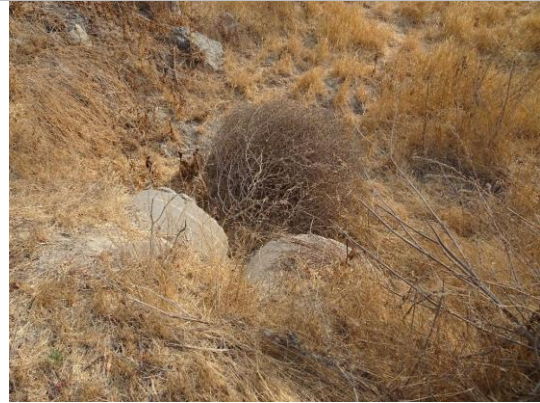
Photo 3 of 3 : UCIP_FA_2024_70680_91049.jpg

Culverts visible past access road.
