Flood Control Project Maintenance Levee Inspections

Fall 2024 Levee Maintenance Deficiency Summary Report

San Joaquin River Basin

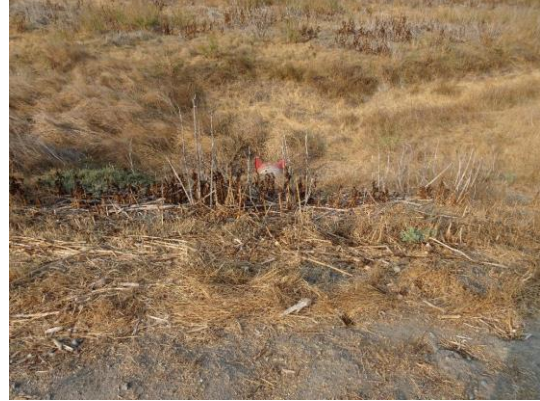
Photo 2 of 3 : UCIP_FA_2024_83246_90923.jpg

WS view: Pipe and flapgate visible at WS toe

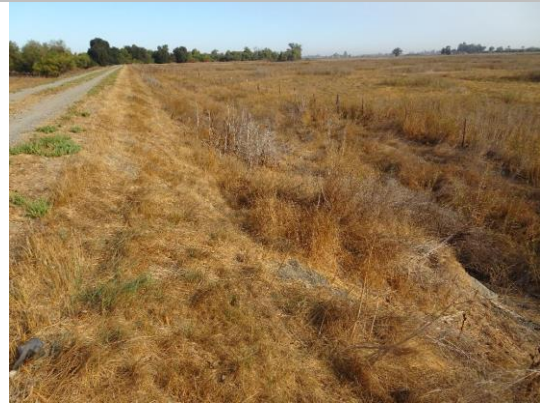
Photo 3 of 3 : UCIP_FA_2024_83246_90925.jpg

LS view: LS toe and pipe headwall

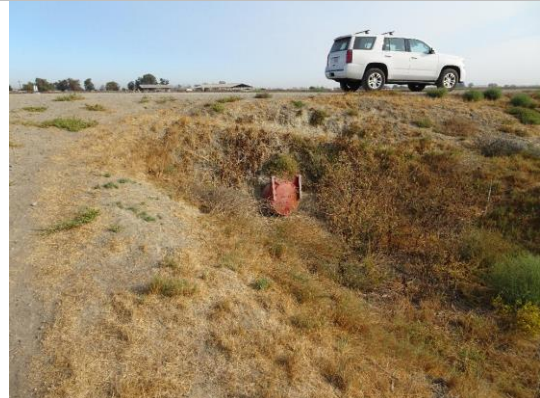
Photo 2 of 3 : UCIP_FA_2024_70683_91010.jpg

Comment Code					
Inspector Comment					
DS_ID:19631 FS_ID:70683 EP_NO: N/A Repair Type: Non-Urgent EVAL Issue: 5, Pipe Damage Crossing Status: Found UCIP Comments: 10/21/2020 Record has been updated from No Action Needed to Non-Urgent. DWR DMP has found integrity issues, LOF between 4 and 5. Crossing will be monitored until funding becomes available for rehabilitation. No permit was found authorizing this encroachment. CVFPB will need to review crossing to determine owner. Pipe material changes from CMP on the WS to concrete on the LS. (B. Singh - GEI, O. Magana - DWR UCIP) FIELD_STRUCT_DESC: 24-inch corrugated metal (CM) gravity drainage pipe through the levee, 7.0 feet below the crown. Flap gate on the waterside (WS) end. Brass cap No. 67 bench mark (BM) on the headwall on the landside (LS). Pipe material changes from CMP on the WS to concrete on the LS. [Additional Reference(s): DWR Levee Log, 2002, (HLM 10.74). USACE San Joaquin O&M Manual, Unit No. 601, Part No. 1, (SJR601.1), 1967, Revised 25 May 2011, (HLM 10.72)]. FS Date: 10/21/2020

WS view: Pipe and flapgate at WS toe

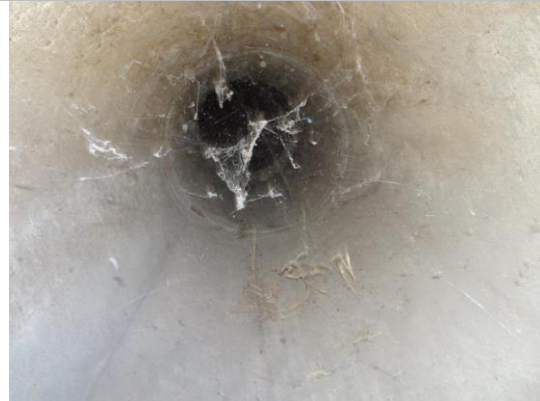
Photo 3 of 3 : UCIP_FA_2024_70683_91013.jpg

LS view: internal view of concrete pipe located on WS.

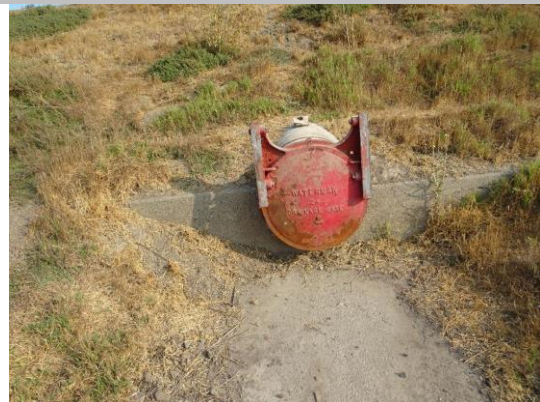
Photo 2 of 3 : UCIP_FA_2024_70684_90933.jpg

WS view: Pipe, flapgate, and headwall at WS toe

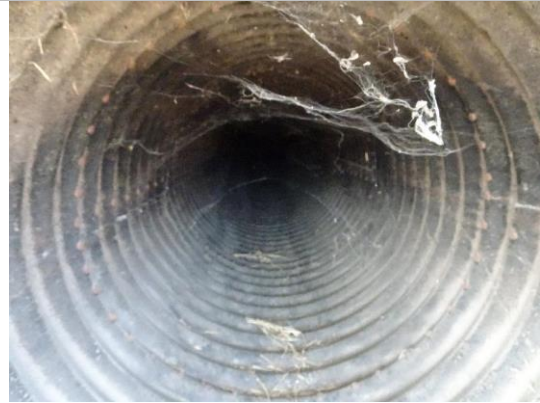
Photo 3 of 3 : UCIP_FA_2024_70684_90928.jpg

LS view: Pipe interior from LS toe

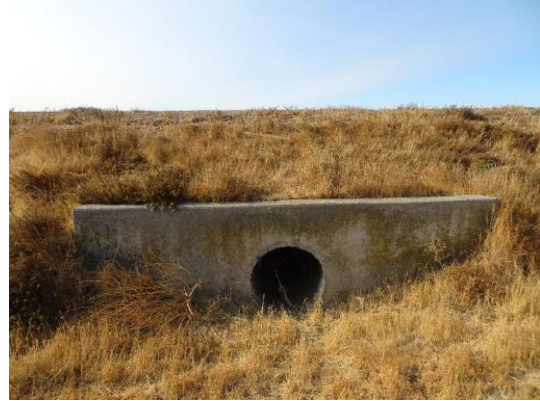
Photo 2 of 3 : UCIP_FA_2024_83255_90938.jpg

LS view: Pipe and headwall at LS toe

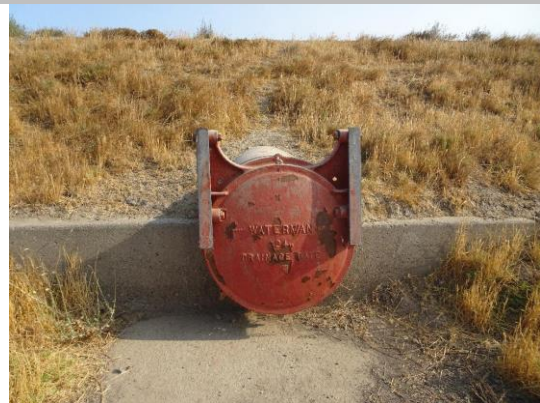
Photo 3 of 3 : UCIP_FA_2024_83255_90934.jpg

DS_ID:19633
 FS_ID:83255
 EP_NO: N/A
 Repair Type: No Action Needed
 EVAL Issue:
 Crossing Status: Found
 UCIP Comments: 04/24/2024 Record updated from Non-Urgent to No Action Needed. DMP internal video inspection has found none or minor pipe defects. (M. Thao - DWR UCIP)
 10/21/2020 Record has been updated from No Action Needed to Non-Urgent. No permit was found authorizing this encroachment. CVFPB will need to review crossing to determine owner. DWR DMP has not found internal issues, LOF between 1 and 2. Recommend inspection in 5 years. (B. Singh - GEI, O. Magana - DWR UCIP)
 FIELD_STRUCT_DESC: 24-inch corrugated metal (CM) gravity drainage pipe through the levee, 5.0 feet below the crown. Flap gate on the waterside (WS) end. Brass cap No. 65 bench mark (BM) on the headwall on the landside (LS). [Additional Reference(s): DWR Levee Log, 2002, (HLM 11.20). USACE San Joaquin O&M Manual, Unit No. 601, Part No. 1, (SJR601.1), 1967, Revised 25 May 2011, (HLM 11.18)].

WS view: Pipe, flapgate, and headwall at WS toe

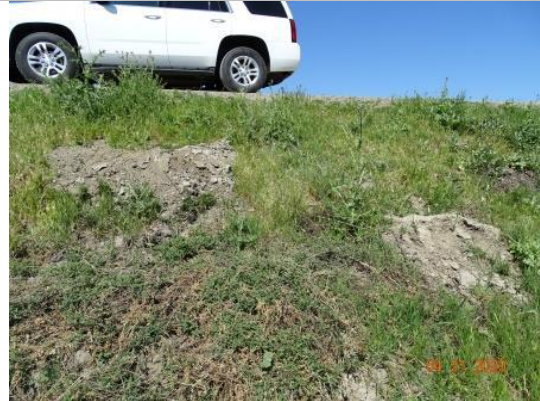
Photo 1 of 1 : FA_2024_NA0010_118_151_20240828_00023.jpg

LM Start	11.37	Rating **	A/W	Issue No.	151
LM End	11.37	Issue Type +	Ma	Location *	LS
Category	Earthen Levee			GPS Latitude/Longitude	
				Start	End
Item	Animal Control			37.275481 °	37.275481 °
				-120.826042 °	-120.826042 °
DWR ID	DWR_NA0010_01_s_2020_151				
Comment Code					
A1 : Exterminate rodents and backfill and compact or grout burrows.					
Inspector Comment

Rodent burrows in the landside slope. (Spring 2020)

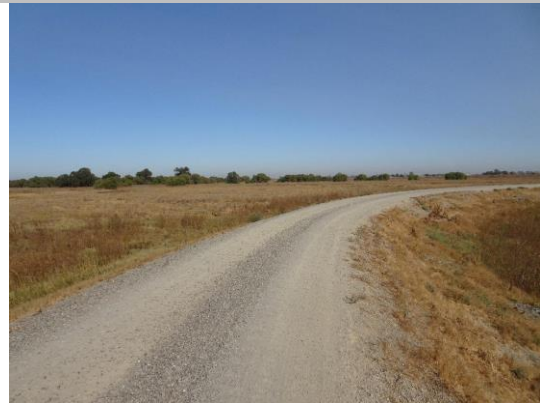
Photo 1 of 3 : UCIP_FA_2024_83256_90940.jpg

Comment Code					
Inspector Comment					
DS_ID:19814 FS_ID:83256 EP_NO: N/A Repair Type: Non-Urgent EVAL Issue: Crossing Status: Found UCIP Comments: 10/21/2020 Record has been updated from No Action Needed to Non-Urgent. Steep slopes prevented further inspection of the WS and LS toes. No permit was found authorizing this encroachment. CVFPB will need to review crossing to determine owner. DWR DMP has not found internal issues, LOF between 1 and 2. Recommend inspection in 5 years. (B. Singh - GEI, O. Magana - DWR UCIP) FIELD_STRUCT_DESC: 24-inch corrugated metal (CM) gravity drainage pipe through the levee, 12.0 feet below the crown. Two metal cutoff walls. Flap gate, concrete saddle, and apron on the waterside (WS) end. Concrete headwall on the landside (LS) end. [Additional Reference(s): DWR Levee Log, 2002. USACE San Joaquin O&M Manual, Unit No. 601, Part No. 1, (SJR601.1), 1967, Revised 25 May 2011, (recorded as Unit 6, HLM 0.05, should be Unit 1, HLM 11.37)]. FS Date: 10/21/2020

Overview of levee crown looking upstream.

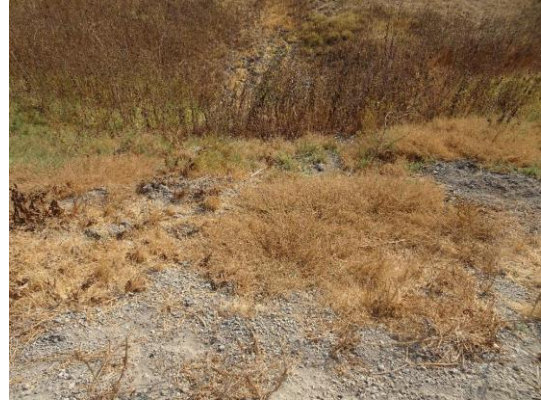
Photo 2 of 3 : UCIP_FA_2024_83256_90943.jpg

LS view: overview of LS slope.

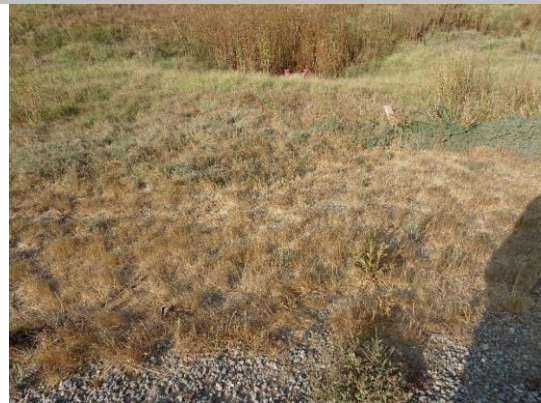
Photo 3 of 3 : UCIP_FA_2024_83256_90942.jpg

WS view: overview of WS slope. Pipe and flapgate visible

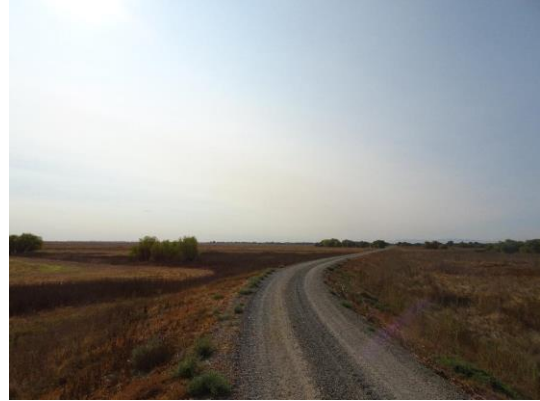
Photo 1 of 3 : UCIP_FA_2024_70687_92836.jpg

Comment Code						
Inspector Comment						
DS_ID:19634 FS_ID:70687 EP_NO: N/A Repair Type: Non-Urgent EVAL Issue: Crossing Status: Found UCIP Comments: 09/18/2023 Pipe was CIPP lined. DMP internal video inspection has found none or minor pipe defects. Recommend next video inspection in 5 years. (O. Yakimov - DWR UCIP) 10/21/2020 Record remains Non-Urgent. Dense vegetation inhibited inspection of pipe and headwall on the LS toe. DWR DMP has found integrity issues, LOF between 4 and 5. Unable to locate pipe inlet on along the LS toe. Crossing will be monitored until funding becomes available for rehabilitation. No permit was found authorizing this encroachment. CVFPB will need to review crossing to determine owner. (B. Singh - GEI, O. Magana - DWR UCIP) 04/25/2014 Need to contact owner--landward side has been buried. It appears that soil was removed from levee toe, immediately upstream, and used to pile soil at landward side at crossing. (O. Magana - DWR UCIP) FIELD_STRUCT_DESC: 24-inch CIPP-lined corrugated metal (CM) gravity drainage pipe through the levee, 10.0 feet below the crown. Flap gate on the waterside (WS) end. Brass cap No. 62 bench mark (BM) on the headwall on the landside (LS). [Additional Reference(s): DWR Levee Log, 2002, (HLM 11.48). USACE San Joaquin O&M Manual, Unit No. 601, Part No. 1, (SJR601.1), 1967, Revised 25 May 2011, (HLM 11.48)]. FS Date: 10/21/2020

Overview of levee crown looking upstream towards pipe crossing, photo 1 of 2.

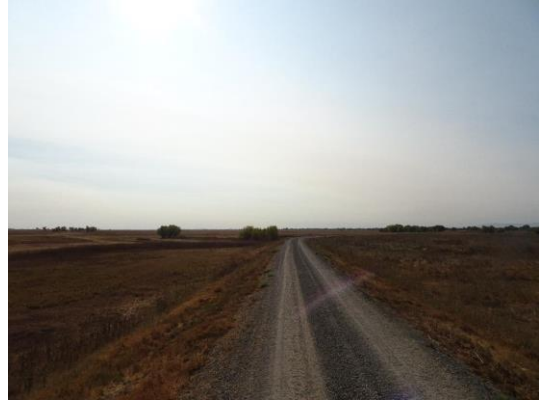
Photo 2 of 3 : UCIP_FA_2024_70687_90946.jpg

Overview of levee crown looking upstream towards pipe crossing, photo 2 of 2.

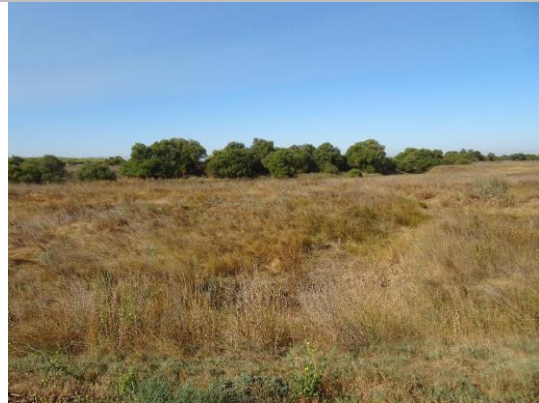
Photo 3 of 3 : UCIP_FA_2024_70687_90947.jpg

WS view: overview of WS.

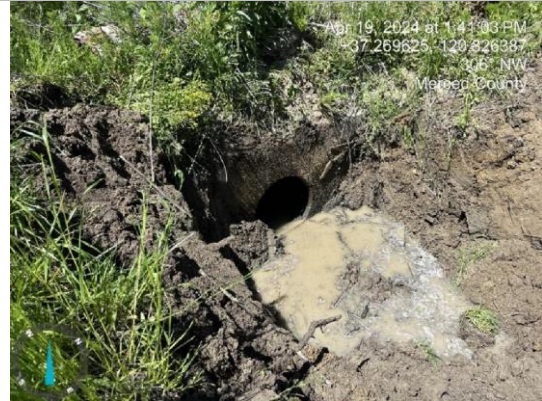
Photo 1 of 3 : UCIP_FA_2024_84499_124855.jpg

DS_ID:19635
FS_ID:84499
EP_NO: N/A
Repair Type: Non-Urgent
EVAL Issue:
Crossing Status: Found
UCIP Comments: 07/11/2024 Record remains Non-Urgent. The pipe inlet and concrete headwall are not longer buried on the LS toe. (M. Thao - DWR UCIP)
10/21/2020 Record remains Non-Urgent. DWR DMP geophysics study found evidence of pipe at 37.269697, -120.826430 (modified levee mile coordinates 37.269657, -120.826471 using UCIP calculator). Pipe and flap gate previously found on the WS toe were covered by dry vegetation preventing proper UCIP inspection. Recommend removal of excess vegetation to conduct a proper inspection of this structure through the levee. The pipe inlet and concrete headwall are buried on the LS toe. No permit was found authorizing this encroachment. CVFPB will need to review crossing to determine owner. (B. Singh - GEI, O. Magana - DWR UCIP)
04/25/2014 Crossing is non-functional -- landward side is buried. Debris found on landward side (channel). Dense vegetation found on waterward slope. Recommend contacting owner to determine status of crossing. If crossing is no longer used need to coordinate with CVFPB for proper abandonment. (O. Magana - DWR UCIP)

LS view: Pipe inlet and concrete headwall on toe.

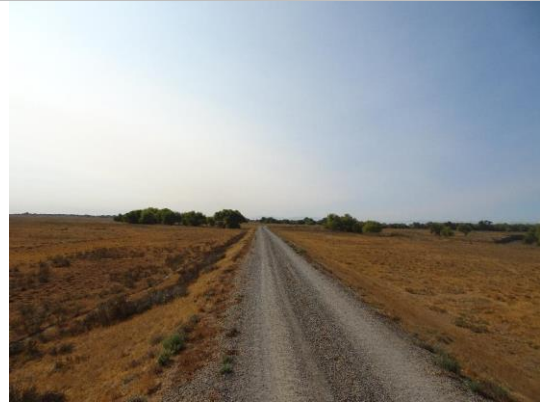
Photo 2 of 3 : UCIP_FA_2024_84499_90950.jpg

Overview of levee crown

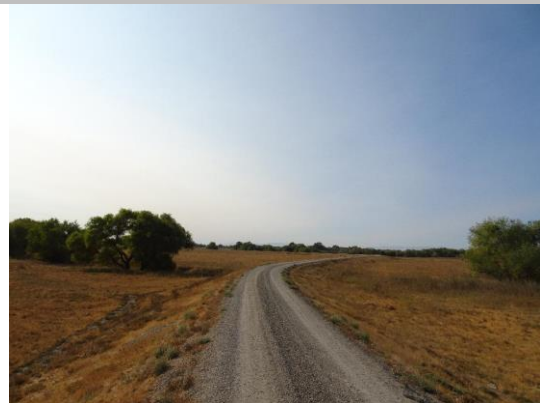
Photo 3 of 3 : UCIP_FA_2024_84499_92838.jpg

Overview of levee crown looking upstream towards pipe.

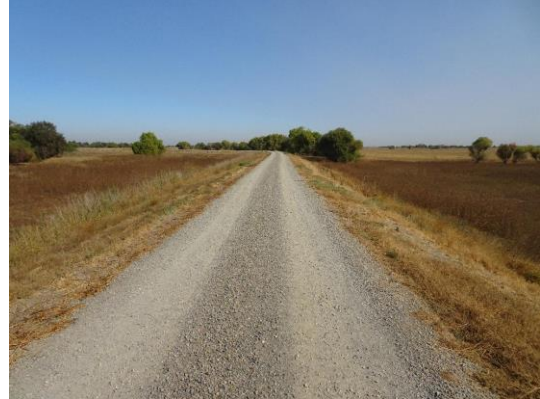
Photo 1 of 3 : UCIP_FA_2024_83274_90956.jpg

Comment Code						
Inspector Comment						
DS_ID:19636 FS_ID:83274 EP_NO: N/A Repair Type: Non-Urgent EVAL Issue: 5, Pipe Damage Crossing Status: Found UCIP Comments: 09/25/2024 DMP internal video inspection has found moderate pipe defects. Crossing will be monitored until funding becomes available for rehabilitation. (O. Yakimov - DWR UCIP) 10/21/2020 Record remains Non-Urgent. Dense vegetation inhibited proper inspection of the pipe on the LS and WS toes. No permit was found authorizing this encroachment. CVFPB will need to review crossing to determine owner. DWR DMP internal inspection is pending and scheduled for 2021. (B. Singh - GEI, O. Magana - DWR UCIP) 04/25/2014 Crossing is non-functional --landward side is buried. Dense vegetation found on waterward slope. Recommend contacting owner to determine status of crossing. If crossing is no longer used need to coordinate with CVFPB for proper abandonment. (O. Magana - DWR UCIP) FIELD_STRUCT_DESC: 24-inch corrugated metal (CM) gravity drainage pipe through the levee, 12.4 feet below the crown. Flap gate on the waterside (WS) end. Brass cap No. 60 bench mark (BM) on the headwall on the landside (LS). [Additional Reference(s): DWR Levee Log, 2002, (HLM 12.12). USACE San Joaquin O&M Manual, Unit No. 601, Part No. 1, (SJR601.1), 1967, Revised 25 May 2011, (HLM 12.11)]. FS Date: 10/21/2020

Overview of levee crown looking upstream.

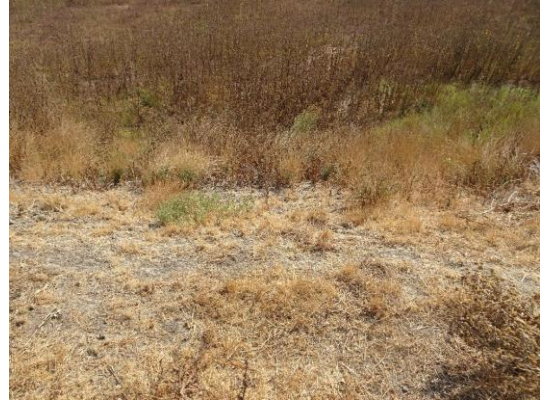
Photo 3 of 3 : UCIP_FA_2024_83274_90961.jpg

LS view: view of LS slope

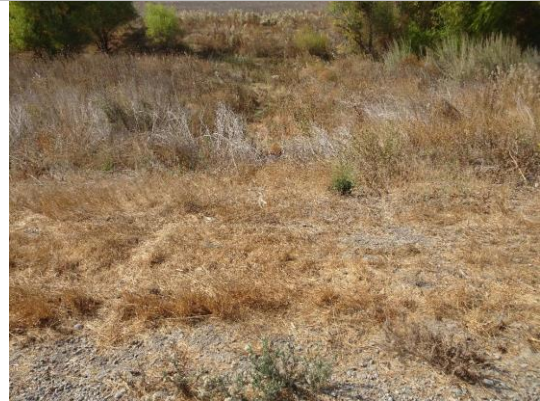
Photo 1 of 3 : UCIP_FA_2024_70690_90966.jpg

Comment Code						
Inspector Comment						
DS_ID:19637 FS_ID:70690 EP_NO: N/A Repair Type: Non-Urgent EVAL Issue: Crossing Status: Found UCIP Comments: 09/15/2023 Pipe was CIPP lined. DMP internal video inspection has found none or minor pipe defects. Recommend next video inspection in 5 years. (O. Yakimov - DWR UCIP) 10/21/2020 Record remains Non-Urgent. DWR DMP has found integrity issues, LOF between 4 and 5. Crossing will be monitored until funding becomes available for rehabilitation. Proper inspection inhibited by dense vegetation. Recommend vegetation removal along pipe alignment. No permit was found authorizing this encroachment. CVFPB will need to review crossing to determine owner. (B. Singh - GEI, O. Magana - DWR UCIP) 04/25/2014 Concrete headwall on landward side blocked by debris. Dense vegetation limits the inspector's visibility to identify signs of pipe failure (leaks) along the landward slope. Recommend removing vegetation along pipe alignment to conduct proper inspection of crossing. (O. Magana - DWR UCIP) FIELD_STRUCT_DESC: 24-inch CIPP-lined corrugated metal (CM) gravity drainage pipe through the levee, 9.5 feet below the crown. Flap gate on the waterside (WS) end. Brass cap No. 60 bench mark (BM) on the headwall on the landside (LS). [Additional Reference(s): DWR Levee Log, 2002, (HLM 12.95). USACE San Joaquin O&M Manual, Unit No. 601, Part No. 1, (SJR601.1), 1967, Revised 25 May 2011, (HLM 12.94)]. FS Date: 10/21/2020

WS view: dense vegetation along WS toe. Pipe and flap gate visible on WS toe.

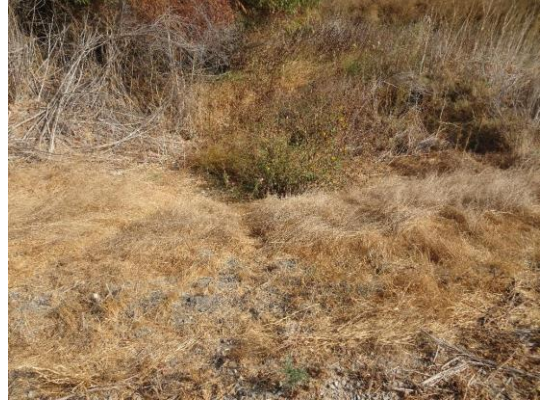
Photo 2 of 3 : UCIP_FA_2024_70690_90964.jpg

LS view: dense vegetation along LS toe. No pipe visible.

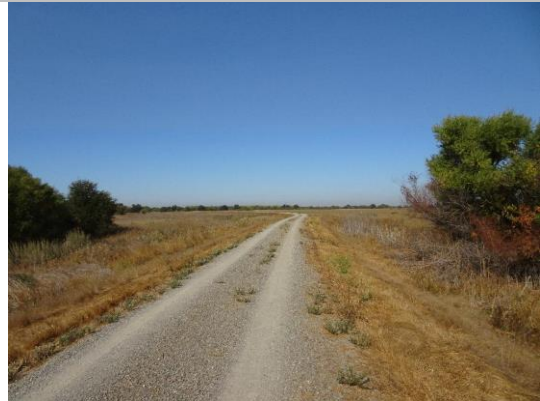
Photo 3 of 3 : UCIP_FA_2024_70690_90962.jpg

Overview of levee crown looking downstream towards pipe crossing.

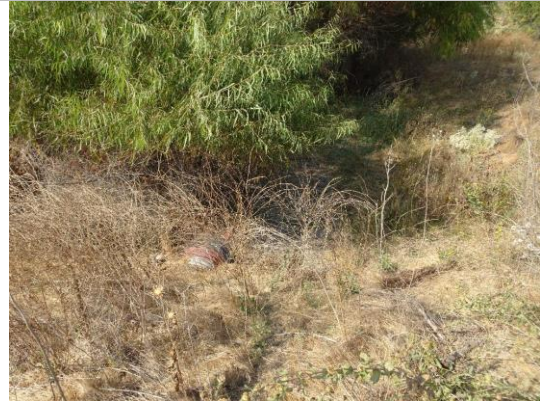
Photo 1 of 2 : UCIP_FA_2024_83258_90969.jpg

Comment Code						
Inspector Comment						
DS_ID:19638 FS_ID:83258 EP_NO: N/A Repair Type: Urgent EVAL Issue: 1, Pipe Integrity Crossing Status: Found UCIP Comments: 12/14/2022 Record updated from Non-Urgent to Urgent. DMP internal video inspection has found pipe integrity issues. LOF of crossing is between 5 and 6. Crossing will be monitored until funding becomes available to address the issues. (O.Yakimov - DWR UCIP) 10/21/2020 Record remains Non-Urgent. No permit was found authorizing this encroachment. CVFPB will need to review crossing to determine owner. DWR DMP internal inspection is pending and scheduled for 2021. (B. Singh - GEI, O. Magana - DWR UCIP) 04/25/2014 Dense vegetation limits the inspector's visibility to identify signs of pipe failure (leaks) along the landward slope. Concrete headwall blocked by debris located on landward toe. Recommend clearing debris from landward slope and toe. (O. Magana - DWR UCIP) FIELD_STRUCT_DESC: 24-inch corrugated metal (CM) gravity drainage pipe through the levee, 14.2 feet below the crown. Flap gate on the waterside (WS) end. Brass cap No. 60 bench mark (BM) on the headwall on the landside (LS). [Additional Reference(s): DWR Levee Log, 2002, (HLM 13.48). USACE San Joaquin O&M Manual, Unit No. 601, Part No. 1, (SJR601.1), 1967, Revised 25 May 2011, (HLM 13.48)]. FS Date: 10/21/2020 1:37:19 PM

WS view: pipe and flapgate visible at WS toe

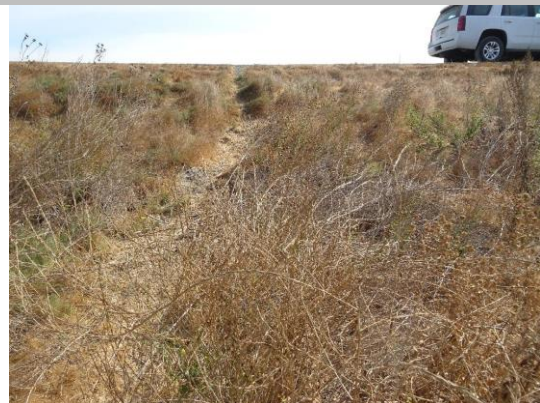
Photo 2 of 2 : UCIP_FA_2024_83258_90970.jpg

LS view: overview of LS slope

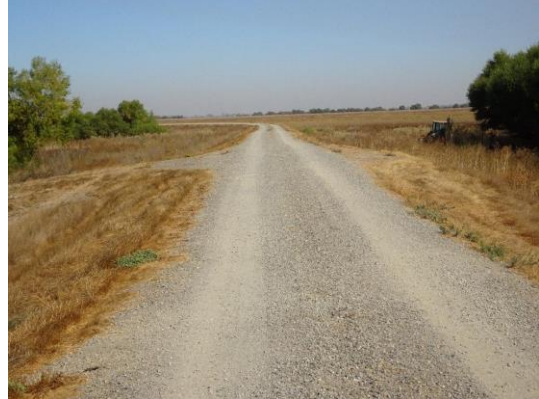
Photo 1 of 3 : UCIP_FA_2024_81163_90971.jpg

Comment Code						
Inspector Comment						
DS_ID:19639 FS_ID:81163 EP_NO: N/A Repair Type: No Action Needed EVAL Issue: Crossing Status: Found UCIP Comments: 09/25/2023 DMP internal video inspection has found none or minor pipe defects. Recommend next video inspection in 5 years. (J. Taylor - DWR UCIP) 10/21/2020 Record remains Non-Urgent. No permit was found authorizing this encroachment. CVFPB will need to review crossing to determine owner. DWR DMP internal inspection is pending and scheduled for 2021. (B. Singh - GEI, O. Magana - DWR UCIP) 10/25/2014 No access to waterward toe due to fence. Unable to find the concrete headwall and flap gate on waterward side past fence. Also dense vegetation limits the inspector's visibility to identify signs of pipe failure (leaks) along the waterward slope. Recommend removing vegetation along pipe alignment to conduct proper inspection of structure. Also need access past fence on waterward side. (O. Magana - DWR UCIP) FIELD_STRUCT_DESC: 24-inch corrugated metal (CM) gravity drainage pipe through the levee, 14.5 feet below the crown. Flap gate on the waterside (WS) end. Brass cap No. 60 bench mark (BM) on the headwall on the landside (LS). [Additional Reference(s): DWR Levee Log, 2002, (HLM 13.58). USACE San Joaquin O&M Manual, Unit No. 601, Part No. 1, (SJR601.1), 1967, Revised 25 May 2011, (HLM 13.58)]. FS Date: 10/21/2020

Overview of levee crown looking downstream towards crossing.

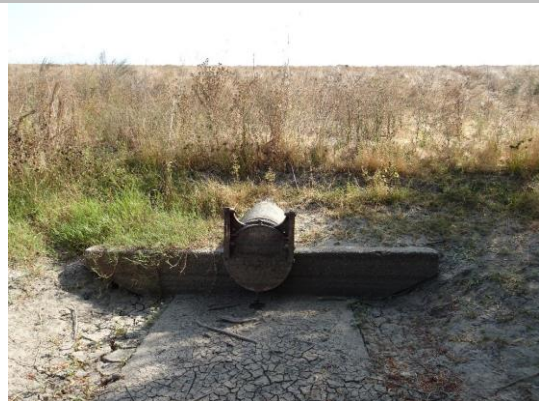
Photo 2 of 3 : UCIP_FA_2024_81163_90974.jpg

WS view: pipe, headwall, and flapgate at WS toe

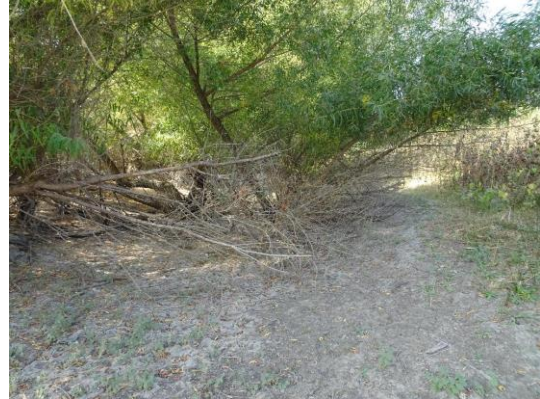
Photo 3 of 3 : UCIP_FA_2024_81163_90975.jpg

WS view: overview looking towards drainage past pipe outlet.

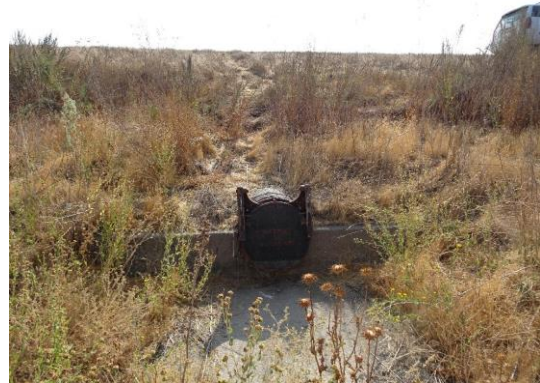
Photo 1 of 3 : UCIP_FA_2024_83261_90984.jpg

DS_ID:19640
FS_ID:83261
EP_NO: N/A
Repair Type: No Action Needed
EVAL Issue:
Crossing Status: Indicator Found
UCIP Comments: 04/24/2024 Record updated from Non-Urgent to No Action Needed. DMP internal video inspection has found none or minor pipe defects. (M. Thao - DWR UCIP)
10/21/2020 Record remains Non-Urgent. No permit was found authorizing this encroachment. CVFPB will need to review crossing to determine owner. DWR DMP has not found internal issues, LOF between 1 and 2. Recommend inspection in 5 years. (B. Singh - GEI, O. Magana - DWR UCIP)
04/25/2014 No photos available--missed crossing. Aerial photograph indicates crossing is present. Need to confirm if crossing is still present on waterward side. (O. Magana - DWR UCIP)
FIELD_STRUCT_DESC: 24-inch corrugated metal (CM) gravity drainage pipe through the levee, 11.0 feet below the crown. Flap gate on the waterside (WS) end. Brass cap No. 60 bench mark (BM) on the headwall on the landside (LS). [Additional Reference(s): DWR Levee Log, 2002, (HLM 13.83). USACE San Joaquin O&M Manual, Unit No. 601, Part No. 1, (SJR601.1), 1967, Revised 25 May 2011, (HLM 13.81)].

WS view: Pipe, flapgate, and headwall at WS toe

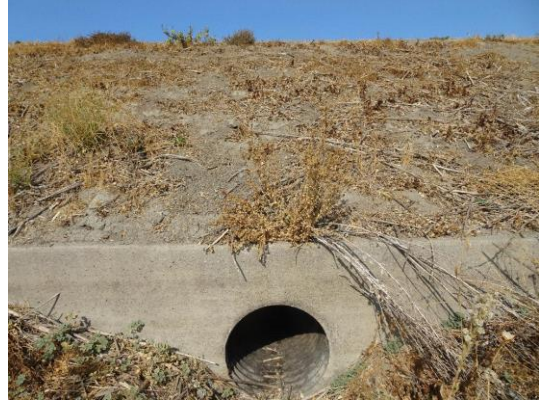
Photo 2 of 3 : UCIP_FA_2024_83261_90982.jpg

LS view: Pipe and headwall at LS toe

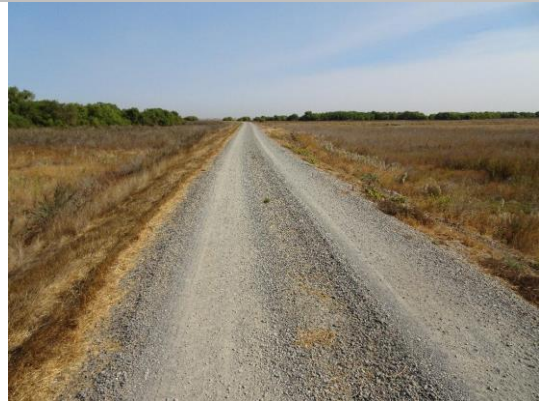
Photo 3 of 3 : UCIP_FA_2024_83261_90977.jpg

Overview of levee crown looking downstream towards crossing.

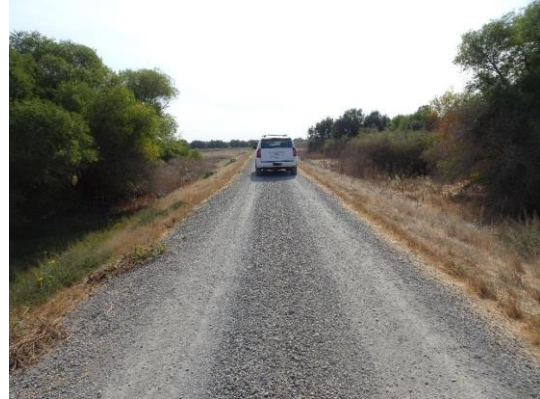
Photo 1 of 3 : UCIP_FA_2024_83262_90986.jpg

Comment Code						
Inspector Comment						
DS_ID:19641 FS_ID:83262 EP_NO: N/A Repair Type: Non-Urgent EVAL Issue: Crossing Status: Found UCIP Comments: 10/21/2020 Record remains Non-Urgent. Dense vegetation at LS and WS toes inhibited proper inspection. No permit was found authorizing this encroachment. CVFPB will need to review crossing to determine owner. DWR DMP has not found internal issues, LOF between 1 and 2. Recommend inspection in 5 years. (B. Singh - GEI, O. Magana - DWR UCIP) 10/25/2014 Dense vegetation limits the inspector's visibility to identify signs of pipe failure (leaks) along the slopes. Recommend removing vegetation along pipe alignment to conduct proper inspection of structure. (O. Magana - DWR UCIP) FIELD_STRUCT_DESC: 24-inch corrugated metal (CM) gravity drainage pipe through the levee, 13.0 feet below the crown. Flap gate on the waterside (WS) end. Brass cap No. 60 bench mark (BM) on the headwall on the landside (LS). [Additional Reference(s): DWR Levee Log, 2002, (HLM 14.22). USACE San Joaquin O&M Manual, Unit No. 601, Part No. 1, (SJR601.1), 1967, Revised 25 May 2011, (HLM 14.21)]. FS Date: 10/21/2020

Overview of levee crown looking upstream towards pipe crossing.

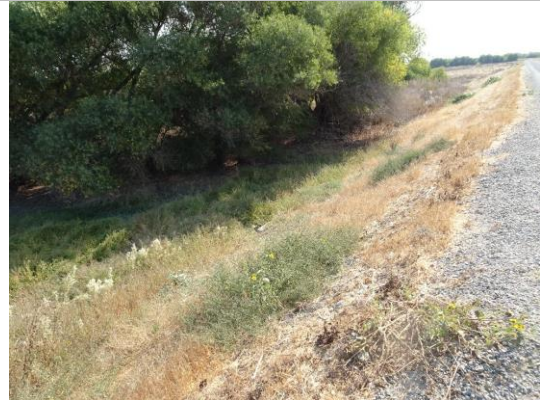
Photo 2 of 3 : UCIP_FA_2024_83262_90988.jpg

LS view: overview of LS

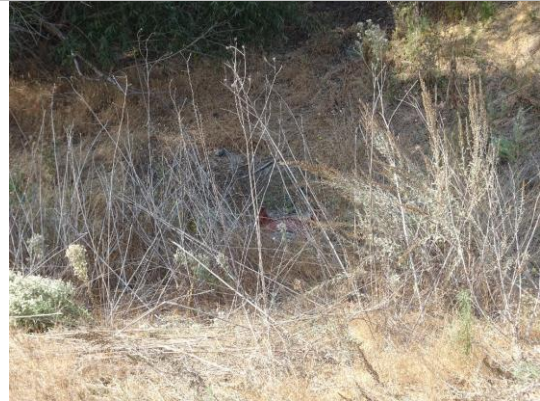
Photo 3 of 3 : UCIP_FA_2024_83262_90985.jpg

WS view: Pipe and flapgate visible through dense vegetation

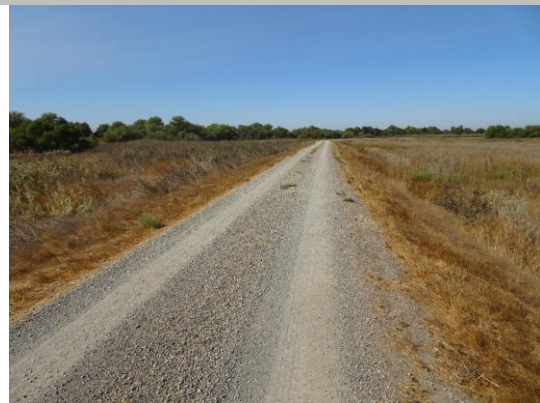
Photo 1 of 3 : UCIP_FA_2024_83263_90992.jpg

DS_ID:19642
FS_ID:83263
EP_NO: N/A
Repair Type: Non-Urgent
EVAL Issue:
Crossing Status: Found
UCIP Comments: 10/21/2020 Record remains Non-Urgent. Dense vegetation along the pipe alignment prevented proper inspection of the levee and pipe. No permit was found authorizing this encroachment. CVFPB will need to review crossing to determine owner. DWR DMP has not found internal issues, LOF between 1 and 2. Recommend inspection in 5 years. (B. Singh - GEI, O. Magana - DWR UCIP)
04/25/2014 Dense vegetation limits the inspector's visibility to identify signs of pipe failure (leaks) along the landward slope and toe. Recommend removing vegetation along pipe alignment to conduct proper inspection of structure. (O. Magana - DWR UCIP)
FIELD_STRUCT_DESC: 24-inch corrugated metal (CM) gravity drainage pipe through the levee, 9.7 feet below the crown. Flap gate on the waterside (WS) end. Brass cap No. 60 bench mark (BM) on the headwall on the landside (LS). [Additional Reference(s): DWR Levee Log, 2002, (HLM 14.65). USACE San Joaquin O&M Manual, Unit No. 601, Part No. 1, (SJR601.1), 1967, Revised 25 May 2011, (HLM 14.65)].

Overview of levee crown looking downstream toward crossing.

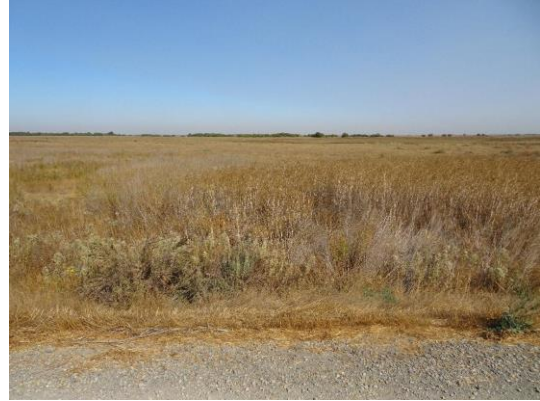
Photo 2 of 3 : UCIP_FA_2024_83263_90995.jpg

LS view: overview of LS

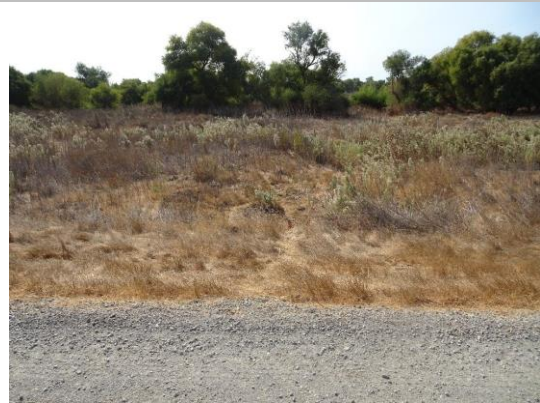
Photo 3 of 3 : UCIP_FA_2024_83263_90997.jpg

WS view: overview of WS

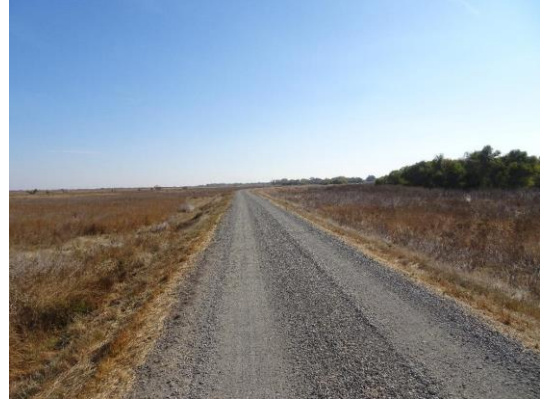
Photo 1 of 3 : UCIP_FA_2024_83264_90792.jpg

DS_ID:19643
FS_ID:83264
EP_NO: N/A
Repair Type: Non-Urgent
EVAL Issue:
Crossing Status: Found
UCIP Comments: 11/16/2020 Record remains Non-Urgent. Dense vegetation on LS toe limited inspection of pipe. Significant burrowing observed on LS and WS slopes. Recommend vegetation removal and rodent mitigation. No permit was found authorizing this encroachment. CVFPB will need to review crossing to determine owner. DWR DMP has not found internal issues, LOF between 1 and 2. Recommend inspection in 5 years. (B. Singh - GEI, O. Magana - DWR UCIP)
04/25/2014 Dense vegetation limits the inspector's visibility to identify signs of pipe failure (leaks) along the landward slope. Recommend removing vegetation along pipe alignment to conduct proper inspection of structure. (O. Magana - DWR UCIP)
FIELD_STRUCT_DESC: 24-inch corrugated metal (CM) gravity drainage pipe through the levee, 9.2 feet below the crown. Flap gate on the waterside (WS) end. Brass cap No. 60 bench mark (BM) on the headwall on the landside (LS). [Additional Reference(s): DWR Levee Log, 2002, (HLM 15.31). USACE San Joaquin O&M Manual, Unit No. 601, Part No. 1, (SJR601.1), 1967, Revised 25 May 2011, (HLM 15.29)].

Overview of levee crown, looking US

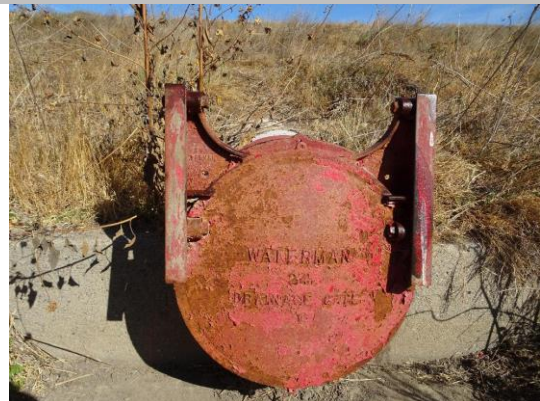
Photo 2 of 3 : UCIP_FA_2024_83264_90794.jpg

WS view: close-up view of pipe, flapgate, and headwall at WS toe

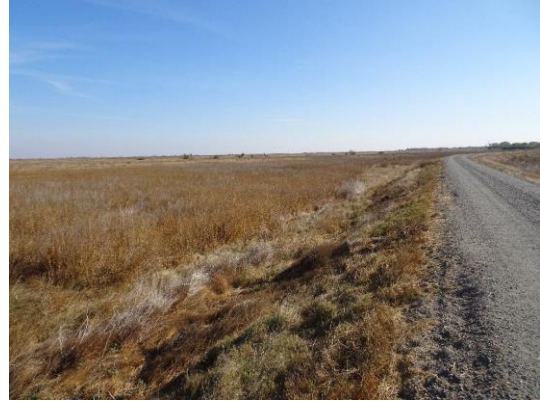
Photo 3 of 3 : UCIP_FA_2024_83264_92867.jpg

LS view: profile view of LS slope

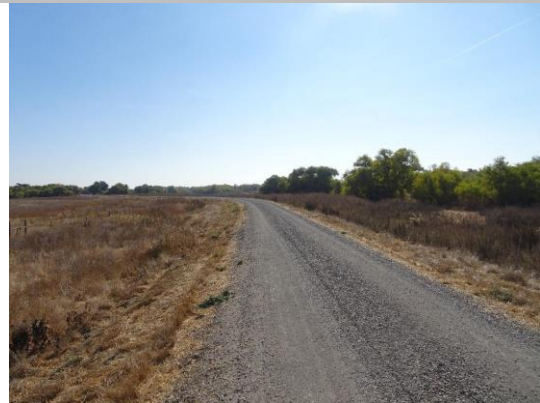
Photo 1 of 3 : UCIP_FA_2024_83265_90797.jpg

DS_ID:19644
FS_ID:83265
EP_NO: N/A
Repair Type: Non-Urgent
EVAL Issue:
Crossing Status: Found
UCIP Comments: 11/16/2020 Recor remains Non-Urgent. Dense vegetation on LS toe and slope inhibited proper inspection of pipe. No permit was found authorizing this encroachment. CVFPB will need to review crossing to determine owner. DWR DMP has not found internal issues, LOF between 1 and 2. Recommend inspection in 5 years. (O. Magana - DWR UCIP, B. Singh - GE04/25/2014 Dense vegetation limits the inspector's visibility to identify signs of pipe failure (leaks) along the waterward and landward slopes. Recommend removing vegetation along pipe alignment to conduct proper inspection of structure. (O. Magana - DWR UCIP)
FIELD_STRUCT_DESC: 24-inch corrugated metal (CM) gravity drainage pipe through the levee, 8.5 feet below the crown. Flap gate on the waterside (WS) end. Brass cap No. 60 bench mark (BM) on the headwall on the landside (LS). [Additional Reference(s): DWR Levee Log, 2002, (HLM 15.57). USACE San Joaquin O&M Manual, Unit No. 601, Part No. 1, (SJR601.1), 1967, Revised 25 May 2011, (HLM 15.57)].

Overview of levee crown, looking US

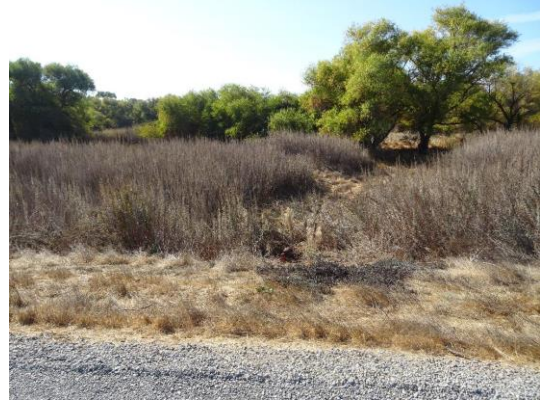
Photo 2 of 3 : UCIP_FA_2024_83265_90798.jpg

WS view: overview of WS. Pipe and flapgate visible at WS toe.

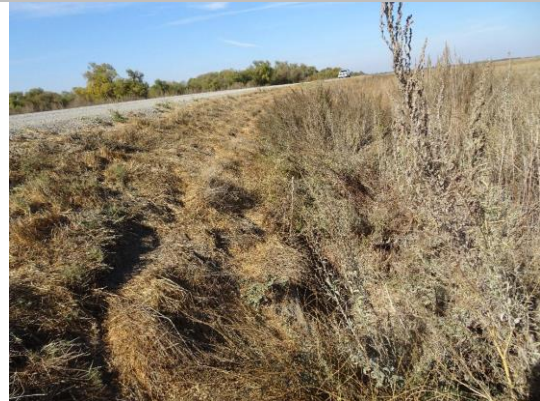
Photo 3 of 3 : UCIP_FA_2024_83265_90799.jpg

LS view: Headwall at LS toe. Dense vegetation inhibited proper inspection of pipe.

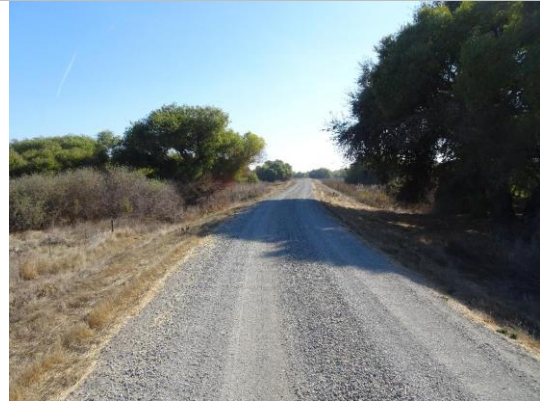
Photo 1 of 3 : UCIP_FA_2024_81164_90803.jpg

DS_ID:19645
FS_ID:81164
EP_NO: N/A
Repair Type: No Action Needed
EVAL Issue:
Crossing Status: Found
UCIP Comments: 09/25/2023 DMP internal video inspection has found none or minor pipe defects. Recommend next video inspection in 5 years. (J. Taylor - DWR UCIP) 11/16/2020 Record remains Non-Urgent. Corrosion observed in pipe inlet on the LS toe. Recommend internal inspection of the pipe through the levee to determine extent of damage. Some burrowing activity found on both LS and WS slope. No permit was found authorizing this encroachment. CVFPB will need to review crossing to determine owner. DWR DMP internal inspection is pending and scheduled for 2021. (B. Singh - GEI, O. Magana - DWR UCIP) 04/25/2014 Dense vegetation limits the inspector's visibility to identify signs of pipe failure (leaks) along the waterward and landward slope. Recommend removing vegetation along pipe alignment to conduct proper inspection of structure. (O. Magana - DWR UCIP) FIELD_STRUCT_DESC: 24-inch corrugated metal (CM) gravity drainage pipe through the levee, 11.0 feet below the crown. Flap gate on the waterside (WS) end. Brass cap No. 60 bench mark (BM) on the headwall on the landside (LS). [Additional Reference(s): DWR Levee Log, 2002, (HLM 15.82). USACE San Joaquin O&M Manual, Unit No. 601, Part No. 1, (SJR601.1), 1967, Revised 25 May 2011, (HLM 15.81)]. FS Date: 11/16/2020

Overview of levee crown, looking US

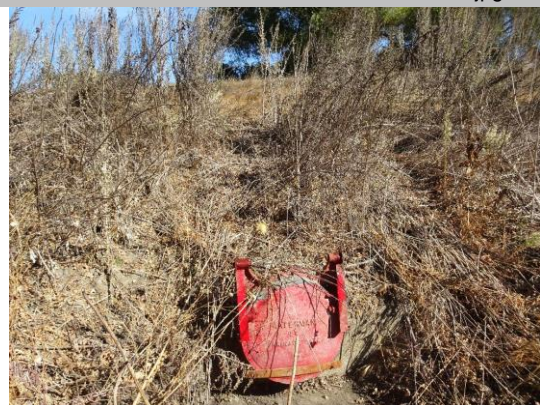
Photo 2 of 3 : UCIP_FA_2024_81164_90806.jpg

WS view: pipe, flapgate, and headwall at WS toe

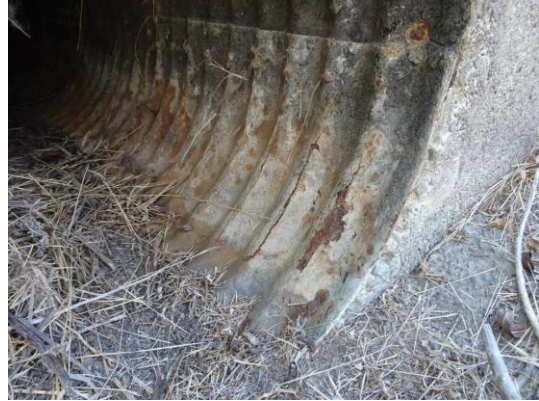
Photo 3 of 3 : UCIP_FA_2024_81164_90801.jpg

LS view: pipe corrosion visible at invert of pipe at LS toe

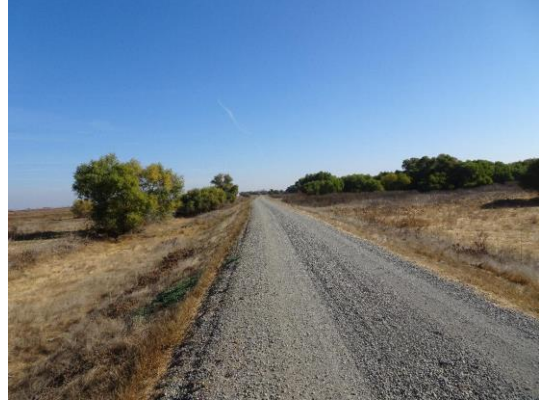
Photo 1 of 3 : UCIP_FA_2024_83267_92966.jpg

Comment Code						
Inspector Comment						
DS_ID:19646 FS_ID:83267 EP_NO: N/A Repair Type: No Action Needed EVAL Issue: Crossing Status: Found UCIP Comments: 04/24/2024 Record updated from Non-Urgent to No Action Needed. DMP internal video inspection has found none or minor pipe defects. (O. Magana - DWR UCIP) 12/20/2022 Record updated from Urgent to Non-Urgent. Pipe has been CIPP-lined. LOF of crossing is less or equal to 4. Recommend next video inspection in 5 years. (O. Yakimov - DWR UCIP) 11/16/2020 Record has been updated from Non-Urgent to Urgent. DWR DMP has found integrity issues, LOF between 5 and 6. Crossing will be monitored until funding becomes available to address. Burrowing activity observed on LS and WS slopes. No permit was found authorizing this encroachment. CVFPB will need to review crossing to determine owner. (B. Singh - GEI, O. Magana - DWR UCIP) 04/25/2014 Dense vegetation limits the inspector's visibility to identify signs of pipe failure (leaks) along the waterward and landward slopes. Recommend removing vegetation along pipe alignment to conduct proper inspection of structure and appurtenances. (O. Magana - DWR UCIP) FIELD_STRUCT_DESC: 24-inch CIPP-lined corrugated metal (CM) gravity drainage pipe through the levee, 11.3 feet below the crown. Flap gate on the waterside (WS) end. Brass cap No. 50 bench mark (BM) on the headwall on the landside (LS). [Additional Reference(s): DWR Levee Log, 2002, (HLM 16.09). USACE San Joaquin O&M Manual, Unit No. 601, Part No. 1, (SJR601.1), 1967, Revised 25 May 2011, (HLM 16.09)]. FS Date: 11/16/2020 9:06:35 AM

Overview of levee looking upstream towards crossing.

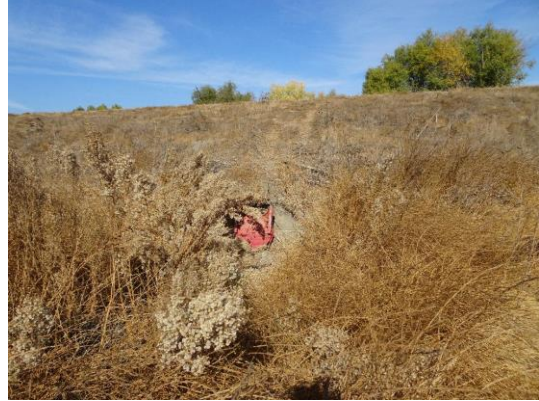
Photo 2 of 3 : UCIP_FA_2024_83267_92965.jpg

WS view: concrete wingwall and pipe with flap gate visible on WS toe.

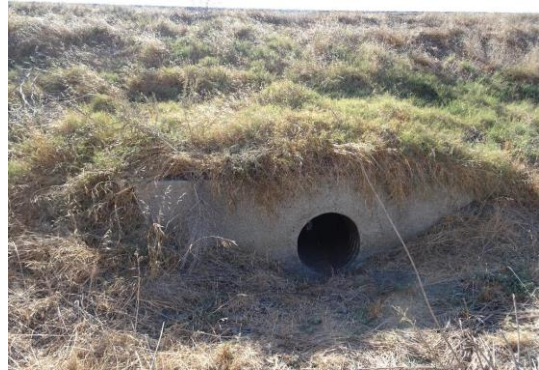
Photo 3 of 3 : UCIP_FA_2024_83267_92964.jpg

LS view: concrete headwall with pipe inlet visible on LS toe.

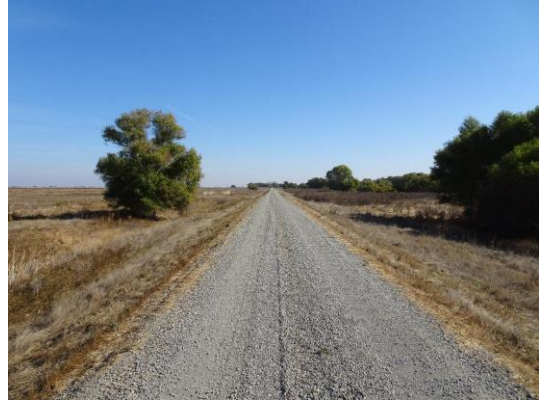
Photo 1 of 3 : UCIP_FA_2024_77854_92979.jpg

Comment Code					
Inspector Comment					
DS_ID:19647 FS_ID:77854 EP_NO: N/A Repair Type: Urgent EVAL Issue: 1, Pipe Integrity Crossing Status: Found UCIP Comments: 12/14/2022 Record updated from Non-Urgent to Urgent. DMP internal video inspection has found pipe integrity issues. LOF of crossing is between 5 and 6. Crossing will be monitored until funding becomes available to address the issues. (O.Yakimov - DWR UCIP) 11/16/2020 Record remains Non-Urgent. Pipe and flapgate on WS toe were under water and there is dense vegetation on the LS slope and toe, inhibiting inspection. No permit was found authorizing this encroachment. CVFPB will need to review crossing to determine owner. DWR DMP internal inspection status is pending. Contacted A. Asrate with DMP staff to find out internal inspection results from 2020. (B. Singh - GEI, O. Magana - DWR UCIP) 04/25/2014 Dense vegetation limits the inspector's visibility to identify signs of pipe failure (leaks) along the waterward and landward slopes. Recommend removing vegetation along pipe alignment to conduct proper inspection of structure. Unable to find pipe on landward side. (O. Magana - DWR UCIP) FIELD_STRUCT_DESC: 24-inch corrugated metal (CM) gravity drainage pipe through the levee, 14.7 feet below the crown. Flap gate on the waterside (WS) end. Brass cap No. 50 bench mark (BM) on the headwall on the landside (LS). [Additional Reference(s): DWR Levee Log, 2002, (HLM 16.16). USACE San Joaquin O&M Manual, Unit No. 601, Part No. 1, (SJR601.1), 1967, Revised 25 May 2011, (HLM 16.15)]. FS Date: 11/16/2020 1:38:40 PM

Overview of levee crown looking upstream towards pipe crossing.

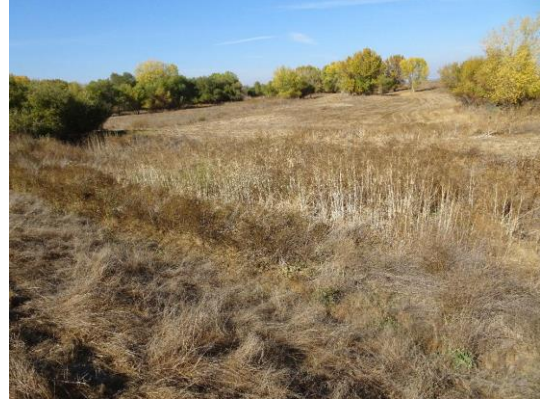
Photo 2 of 3 : UCIP_FA_2024_77854_92980.jpg

LS view: overview of LS.

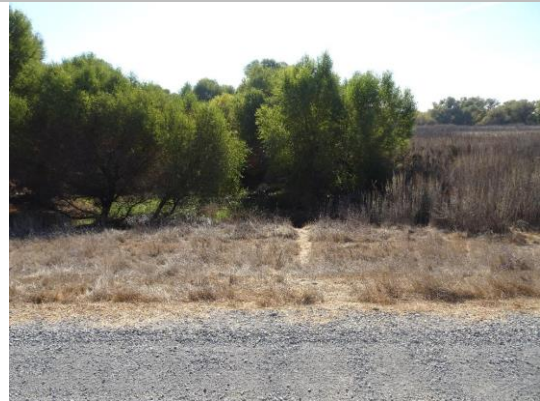
Photo 3 of 3 : UCIP_FA_2024_77854_92978.jpg

WS view: overview of WS.

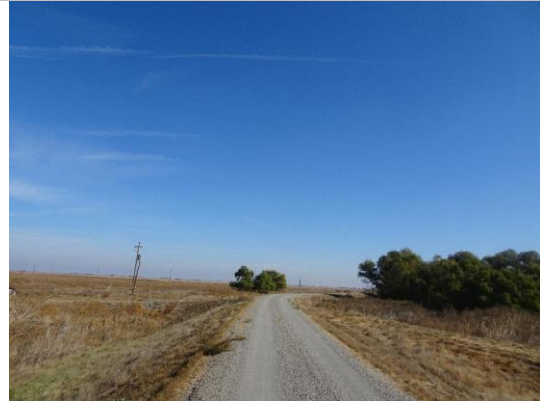
Photo 1 of 3 : UCIP_FA_2024_70701_90813.jpg

Comment Code						
Inspector Comment						
DS_ID:19649 FS_ID:70701 EP_NO: 13549 Repair Type: Non-Urgent EVAL Issue: 10, Unauthorized Modification or Non-Compliant Permit Crossing Status: Not Found UCIP Comments: 11/16/2020 Record remains Non-Urgent. Gravity drainage pipe through the levee, 2 feet below the crown, was measured at 12 inches instead of 30 inches pipe. Pump and concrete standpipe at the center of the levee were not found, and a siphon breaker was not found on the LS shoulder. Recommend a detail review of permit and record files to determine what was constructed at this location and the alignment of the pipe. Need to contact owner to obtain permit authorizing modifications to previously approved 30-inch pipe. (B. Singh - GEI, O. Magana - DWR UCIP) FIELD_STRUCT_DESC: 30-inch coated steel irrigation discharge pipe through the levee, 2.0 feet below the crown. Steel cutoff walls around the pipe at the center of the levee. Siphon breaker on the apex of the pipe on the landside (LS) shoulder. Pump and concrete standpipe on the waterside (WS). Pipe extends to existing irrigation ditch off the LS toe. (Concrete irrigation pipe stand, 60-horsepower [hp] pump, 30-inch steel pipe, and enlarged diversion channel from the river to the pump intake authorized under Permit No. 13549, 1983 - Joseph E. Gallo). [Additional Reference(s): DWR Levee Log, 2002, (HLM 16.73)]. FS Date: 11/16/2020

Overview of levee crown, looking US

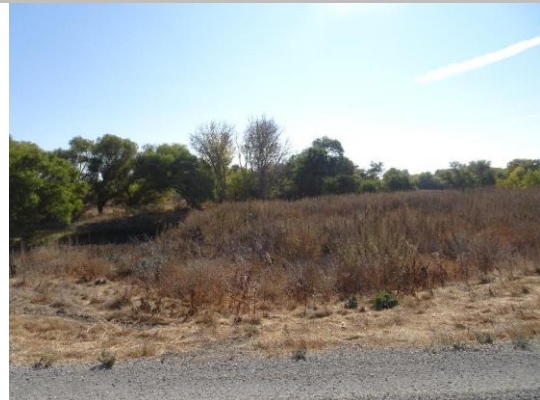
Photo 2 of 3 : UCIP_FA_2024_70701_90814.jpg

WS view: overview of WS. Pipe not found at WS toe and dense vegetation.

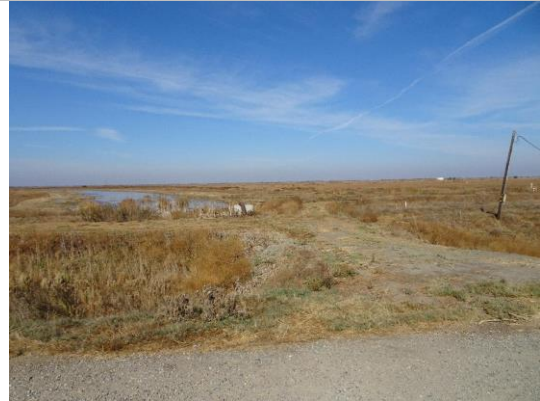
Photo 3 of 3 : UCIP_FA_2024_70701_90815.jpg

LS view: overview of LS. Concrete cone with 12" pipe found.

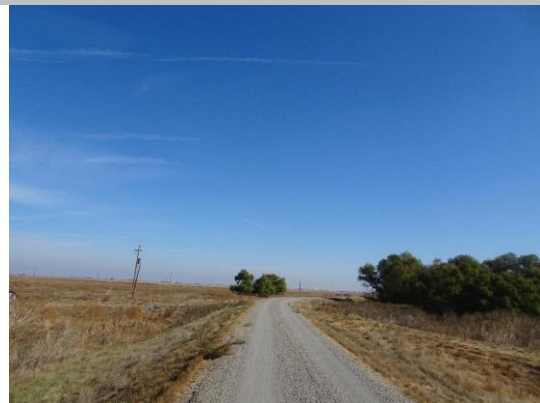
Photo 1 of 3 : UCIP_FA_2024_81165_90820.jpg

DS_ID:19648
FS_ID:81165
EP_NO: N/A
Repair Type: Non-Urgent
EVAL Issue:
Crossing Status: Found
UCIP Comments: 09/25/2023 DMP internal video inspection has found none or minor pipe defects. Recommend next video inspection in 5 years. (J. Taylor - DWR UCIP) 11/16/2020 Record remains Non-Urgent. Unable to locate pipe on both LS and WS toes due to dense vegetation. Recommend vegetation removal for proper inspections. DWR DMP internal inspection is pending and scheduled for 2021. No permit was found authorizing this encroachment. CVFPB will need to review crossing to determine owner. (B. Singh - GEI, O. Magana - DWR UCIP) 04/25/2014 Dense vegetation limits the inspector's visibility to identify signs of pipe failure (leaks) along the waterward and landward slopes. Recommend removing vegetation along pipe alignment to conduct proper inspection of structure. Unable to find pipe on landward side. (O. Magana - DWR UCIP)

Overview of levee crown, looking US

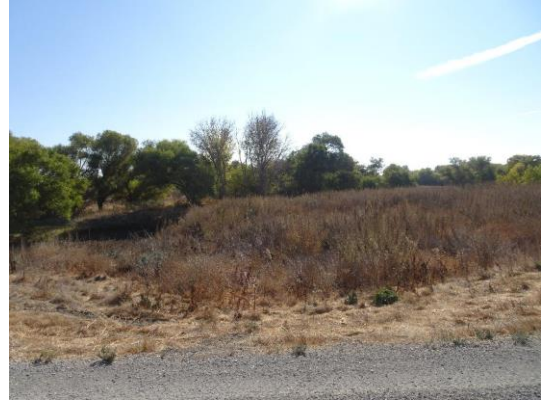
Photo 2 of 3 : UCIP_FA_2024_81165_90821.jpg

WS view: overview of WS. Pipe and flapgate not found; dense vegetation.

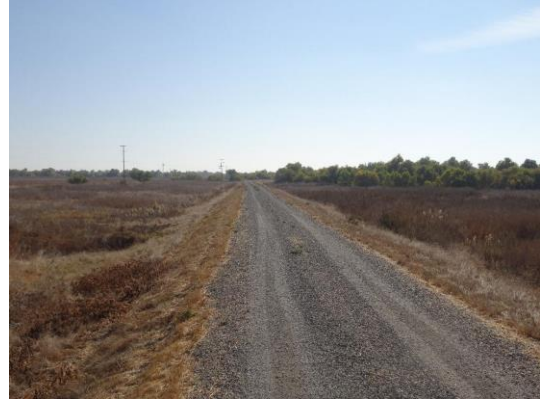
Photo 1 of 3 : UCIP_FA_2024_83268_90825.jpg

Comment Code						
Inspector Comment						
DS_ID:19577 FS_ID:83268 EP_NO: N/A Repair Type: No Action Needed EVAL Issue: Crossing Status: Found UCIP Comments: 04/24/2024 Record updated from Non-Urgent to No Action Needed. DMP internal video inspection has found none or minor pipe defects. (M. Thao - DWR UCIP) 11/16/2020 Record remains Non-Urgent. No permit was found authorizing this encroachment. CVFPB will need to review crossing to determine owner. DWR DMP has not found internal issues, LOF between 1 and 2. Recommend inspection in 5 years. (B. Singh - GEI, O. Magana - DWR UCIP) 04/25/2014 Dense vegetation limits the inspector's visibility to identify signs of pipe failure (leaks) along the waterward and landward slopes. Concrete headwall is buried by dense vegetation. Recommend removing vegetation along pipe alignment to conduct proper inspection of structure. (O. Magana - DWR UCIP) FIELD_STRUCT_DESC: 24-inch corrugated metal (CM) gravity drainage pipe through the levee, 11.5 feet below the crown. Flap gate on the waterside (WS) end. Brass cap No. 50 bench mark (BM) on the headwall on the landside (LS). [Additional Reference(s): DWR Levee Log, 2002, (HLM 17.01). USACE San Joaquin O&M Manual, Unit No. 601, Part No. 1, (SJR601.1), 1967, Revised 25 May 2011, (HLM 17.01)]. FS Date: 11/16/2020

Overview of levee crown, looking US

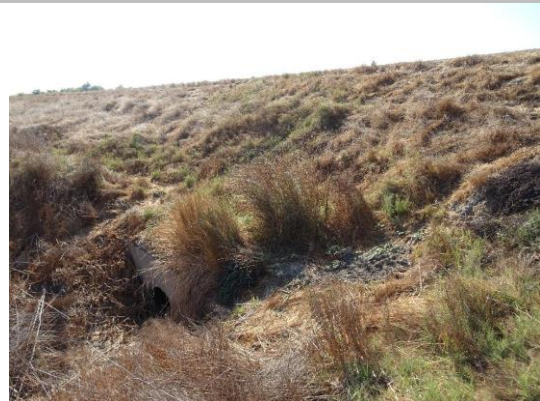
Photo 2 of 3 : UCIP_FA_2024_83268_90827.jpg

LS view: slope above pipe and headwall from LS toe

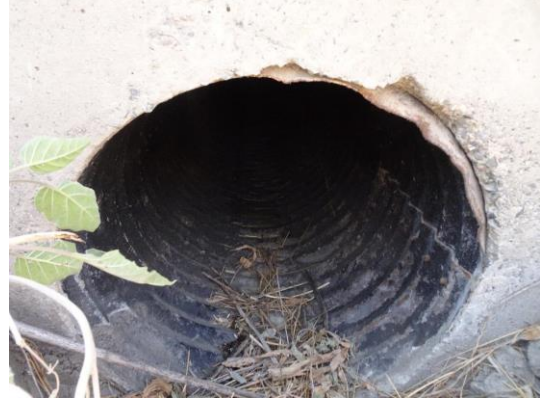
Photo 3 of 3 : UCIP_FA_2024_83268_90829.jpg

LS view: minor damage to headwall concrete at inlet on LS toe.

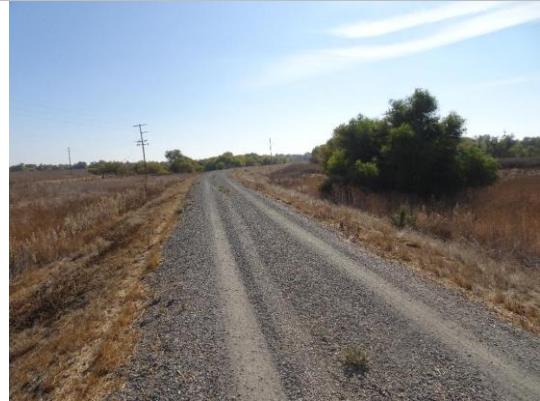
Photo 1 of 3 : UCIP_FA_2024_83270_93002.jpg

DS_ID:19578
FS_ID:83270
EP_NO: N/A
Repair Type: No Action Needed
EVAL Issue:
Crossing Status: Found
UCIP Comments: 04/24/2024 Record updated from Non-Urgent to No Action Needed. DMP internal video inspection has found none or minor pipe defects. (M. Thao - DWR UCIP)
11/16/2020 Record remains Non-Urgent. No permit was found authorizing this encroachment. CVFPB will need to review crossing to determine owner. DWR DMP has not found internal issues, LOF between 1 and 2. Recommend inspection in 5 years. (B. Singh - GEI, O. Magana - DWR UCIP)
04/25/2014 Dense vegetation limits the inspector's visibility to identify signs of pipe failure (leaks) along the waterward and landward slopes. Recommend removing vegetation along pipe alignment to conduct proper inspection of structure. Sediment buildup inside pipe visible from landward side. Recommend clearing pipe. (O. Magana - DWR UCIP)
FIELD_STRUCT_DESC: 24-inch corrugated metal (CM) gravity drainage pipe through the levee, 11.5 feet below the crown. Flap gate on the waterside (WS) end. Brass cap No. 50 bench mark (BM) on the headwall on the landside (LS). [Additional Reference(s): DWR Levee Log, 2002, (HLM 17.20). USACE San Joaquin O&M Manual, Unit No. 601, Part No. 1, (SJR601.1), 1967, Revised 25 May 2011, (HLM 17.19)].

Overview of levee crown looking upstream towards pipe crossing.
