Flood Control Project Maintenance Levee Inspections

Fall 2024 Levee Maintenance Deficiency Summary Report

San Joaquin River Basin

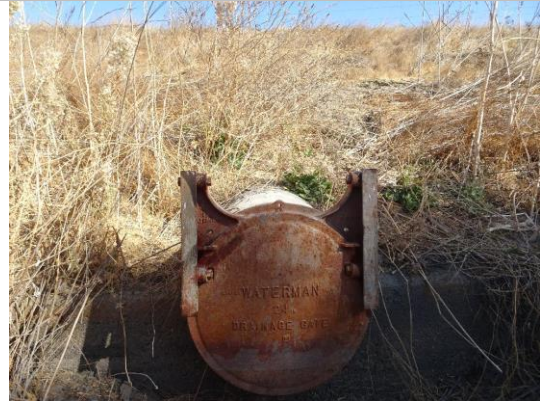
Photo 2 of 3 : UCIP_FA_2024_83270_93001.jpg

WS view: close up of flap gate, pipe, and concrete headwall.

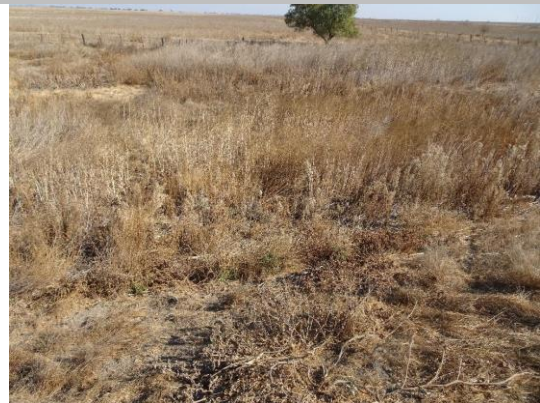
Photo 3 of 3 : UCIP_FA_2024_83270_93005.jpg

LS view: dense vegetation along LS toe.

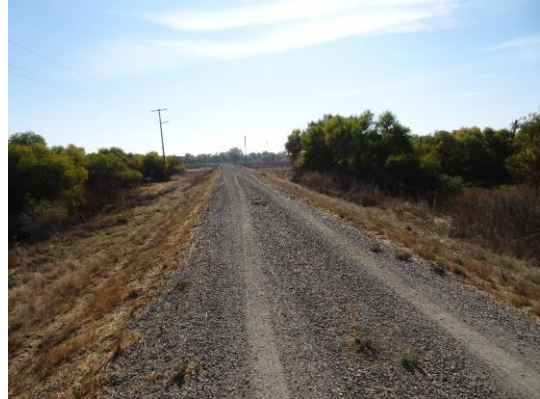
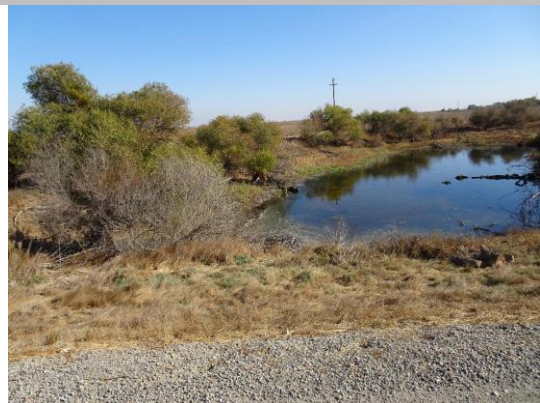
LM Start	17.26	Rating **	U	Issue No.	1250 (cont)
LM End	17.26	Issue Type +	Ma	Location *

DS_ID:19579
FS_ID:81000
EP_NO: N/A
Repair Type: Urgent
EVAL Issue: 1, Pipe Integrity
Crossing Status: Found
UCIP Comments: 09/15/2023 Record updated from Non-Urgent to Urgent. DMP internal video inspection has found severe pipe defects. Crossing will be monitored until funding becomes available to address the issues. (O. Yakimov - DWR UCIP)
11/16/2020 Record remains Non-Urgent. Debris is blocking flapgate on the WS inlet. No permit was found authorizing this encroachment. CVFPB will need to review crossing to determine owner. DWR DMP internal inspection is pending and scheduled for 2021. (B. Singh - GEI, O. Magana - DWR UCIP)
4/25/2014 Dense vegetation limits the inspector's visibility to identify signs of pipe failure (leaks) along the waterward and landward slope. Recommend removing vegetation along pipe alignment to conduct proper inspection of structure. (O. Magana - DWR UCIP)
FIELD_STRUCT_DESC: 24-inch corrugated metal (CM) gravity drainage pipe through the levee, 15.8 feet below the crown. Flap gate on the waterside (WS) end. Brass cap No. 50 bench mark (BM) on the headwall on the landside (LS). [Additional Reference(s): DWR Levee Log, 2002, (HLM 17.27). USACE San Joaquin O&M Manual, Unit No. 601, Part No. 1, (SJR601.1), 1967, Revised 25 May 2011, (HLM 17.26)].

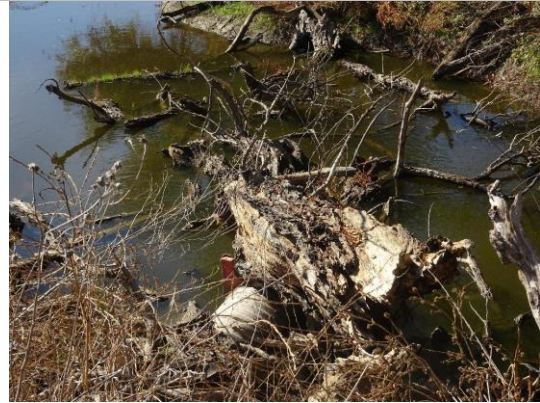
Photo 3 of 3 : UCIP_FA_2024_81000_90837.jpg

WS view: debris blocking pipe flapgate at WS toe.

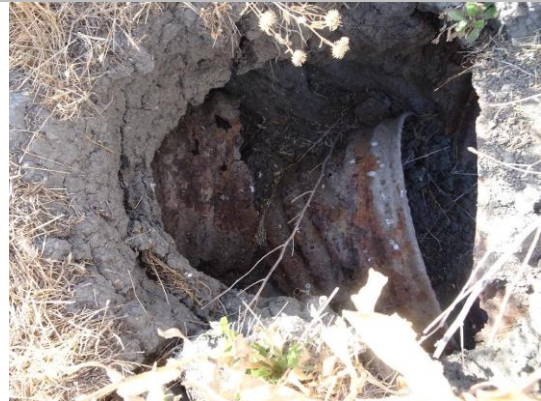
Photo 3 of 3 : UCIP_FA_2024_70707_90838.jpg

DS_ID:19580
FS_ID:70707
EP_NO: N/A
Repair Type: Urgent
EVAL Issue: 1, Pipe Integrity
Crossing Status: Found
UCIP Comments: 11/16/2020 Record has been updated from Non-Urgent to Urgent. Pipe in failed condition on the LS. Potential sink hole located about 1 foot from the LS toe. No permit was found authorizing this encroachment. CVFPB will need to review crossing to determine owner. DWR DMP internal inspection is pending and scheduled for 2021. (B. Singh - GEI, O. Magana - DWR UCIP) 4/25/2014 Dense vegetation limits the inspector's visibility to identify signs of pipe failure (leaks) along the landward slope. Recommend removing vegetation along pipe alignment to conduct proper inspection of structure. (O. Magana - DWR UCIP)
FIELD_STRUCT_DESC: 24-inch corrugated metal (CM) gravity drainage pipe through the levee, 9.5 feet below the crown. Flap gate on the waterside (WS) end. Brass cap No. 50 bench mark (BM) on the headwall on the landside (LS). [Additional Reference(s): DWR Levee Log, 2002, (HLM 17.53). USACE San Joaquin O&M Manual, Unit No. 601, Part No. 1, (SJR601.1), 1967, Revised 25 May 2011, (HLM 17.53)].

LS view: Pipe collapse visible in sinkhole along pipe alignment, photo 2 of 2.

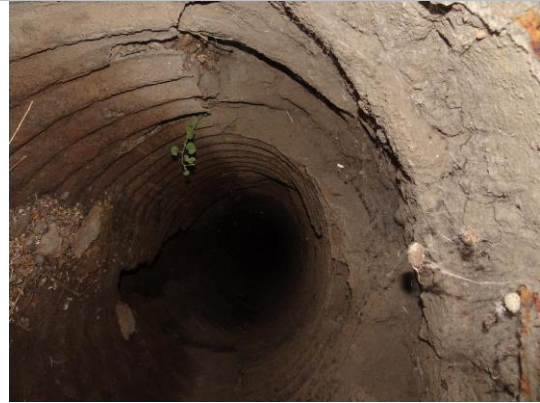
Photo 3 of 3 : UCIP_FA_2024_70708_90848.jpg

Comment Code					
Inspector Comment					
DS_ID:19581 FS_ID:70708 EP_NO: N/A Repair Type: Urgent EVAL Issue: 1, Pipe Integrity Crossing Status: Found UCIP Comments: 11/16/2020 Record has been updated from Non-Urgent to Urgent. Considerable damage to the pipe interior is visible from LS toe. DWR DMP has found integrity issues, LOF between 5 and 6. Crossing will be monitored until funding becomes available to address. No permit was found authorizing this encroachment. CVFPB will need to review crossing to determine owner. (B. Singh - GEI, O. Magana - DWR UCIP) 4/25/2014 Need to contact owner. Recommend investigating integrity of pipe wall through levee heavy corrosion visible from landward side. (O. Magana - DWR UCIP) FIELD_STRUCT_DESC: 24-inch corrugated metal (CM) gravity drainage pipe through the levee, 11.5 feet below the crown. Flap gate on the waterside (WS) end. Brass cap No. 50 bench mark (BM) on the headwall on the landside (LS). [Additional Reference(s): DWR Levee Log, 2002, (HLM 18.21). USACE San Joaquin O&M Manual, Unit No. 601, Part No. 1, (SJR601.1), 1967, Revised 25 May 2011, (HLM 18.19)]. FS Date: 11/16/2020

LS view: Considerable damage observed at LS inlet

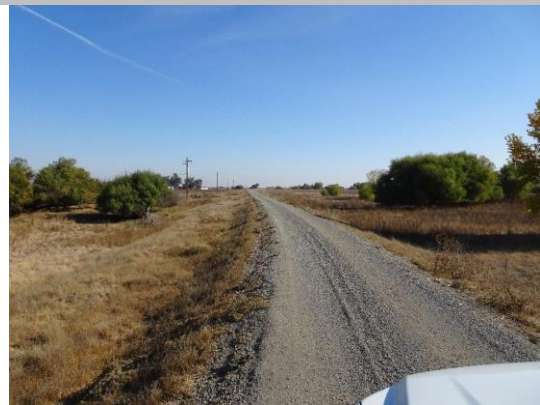
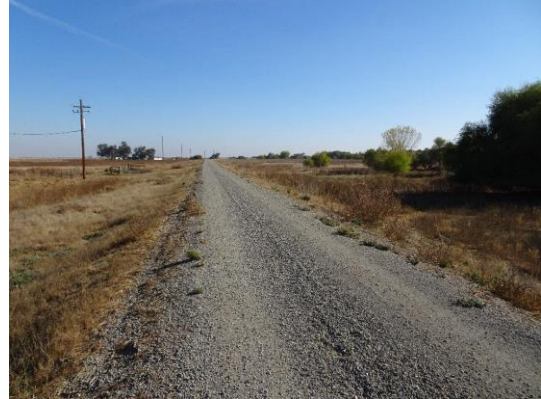
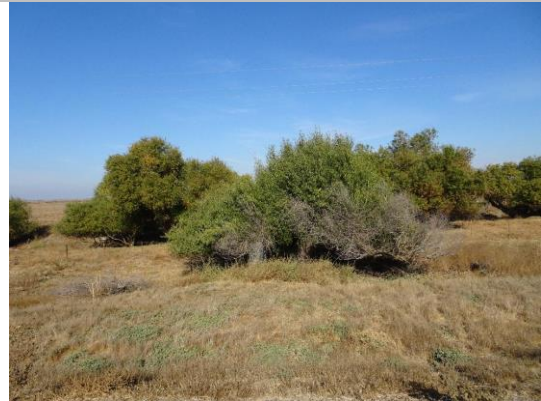
Photo 1 of 3 : UCIP_FA_2024_70709_93037.jpg

DS_ID:19582
FS_ID:70709
EP_NO: N/A
Repair Type: Urgent
EVAL Issue: 1, Pipe Integrity
Crossing Status: Found
UCIP Comments: 11/16/2020 Record has been updated from No Action Needed to Urgent. DWR DMP has found integrity issues, LOF between 5 and 6. No damage observed on the levee during the field inspection. Crossing will be monitored until funding becomes available to address. No permit was found authorizing this encroachment. CVFPB will need to review crossing to determine owner. (B. Singh - GEI, O. Magana - DWR UCIP)
FIELD_STRUCT_DESC: 24-inch corrugated metal (CM) gravity drainage pipe through the levee, 9.4 feet below the crown. Flap gate on the waterside (WS) end. Brass cap No. 50 bench mark (BM) on the headwall on the landside (LS). [Additional Reference(s): DWR Levee Log, 2002, (HLM 18.47). USACE San Joaquin O&M Manual, Unit No. 601, Part No. 1, (SJR601.1), 1967, Revised 25 May 2011, (HLM 18.45)].

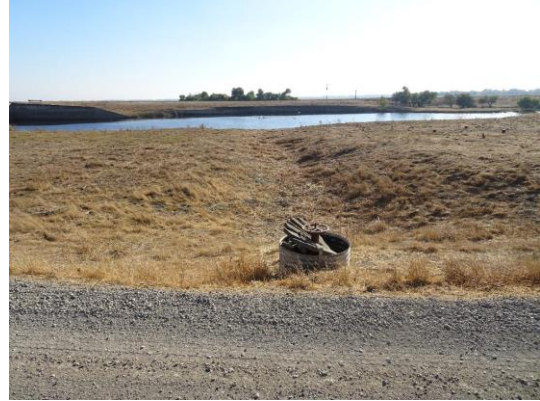
Photo 2 of 3 : UCIP_FA_2024_70712_90862.jpg

Pipe riser visible on WS slope

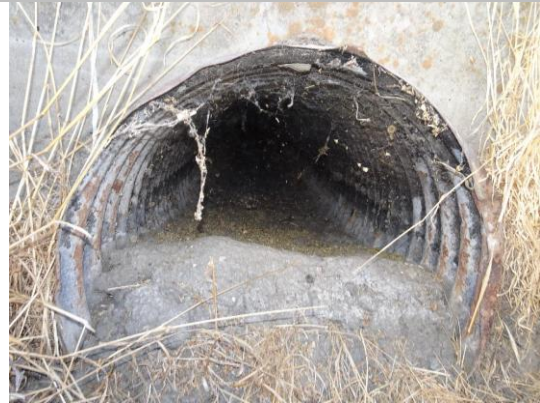
Photo 3 of 3 : UCIP_FA_2024_70712_90857.jpg

Comment Code						
Inspector Comment						
DS_ID:19594 FS_ID:70712 EP_NO: N/A Repair Type: Non-Urgent EVAL Issue: 5, Pipe Damage Crossing Status: Found UCIP Comments: 09/25/2024 DMP internal video inspection has found moderate pipe defects. Crossing will be monitored until funding becomes available for rehabilitation. (O. Yakimov - DWR UCIP) 11/16/2020 Record remains Non-Urgent. Unable to locate pipe on the WS. Pipe appears to be buried on WS. Sediment build-up observed at the LS inlet. Recommend sediment removal and evaluation of pipe's purpose. Pipe is currently non-functional. No permit was found authorizing this encroachment. CVFPB will need to review crossing to determine owner. DWR DMP internal inspection is pending and scheduled for 2021. Recommend adding riser cover on the WS as a safety measure. (B. Singh - GEI, O. Magana - DWR UCIP) 04/25/2014 Non-functional crossing--pipe is buried on waterward side. Sediment buildup in pipe visible from landward side. Need to coordinate with owner to determine status. If crossing is no longer in use, owner will need to coordinate with DWR Inspector and CVFPB to properly abandon. (O. Magana - DWR UCIP) FIELD_STRUCT_DESC: 24-inch corrugated metal (CM) gravity drainage pipe through the levee, 13.0 feet below the crown. Flap gate on the waterside (WS) end. Brass cap No. 40 bench mark (BM) on the headwall on the landside (LS). [Additional Reference(s): DWR Levee Log, 2002, (HLM 19.18). USACE San Joaquin O&M Manual, Unit No. 601, Part No. 1, (SJR601.1), 1967, Revised 25 May 2011, (HLM 19.17)]. FS Date: 11/16/2020

Considerable sediment build-up at LS inlet

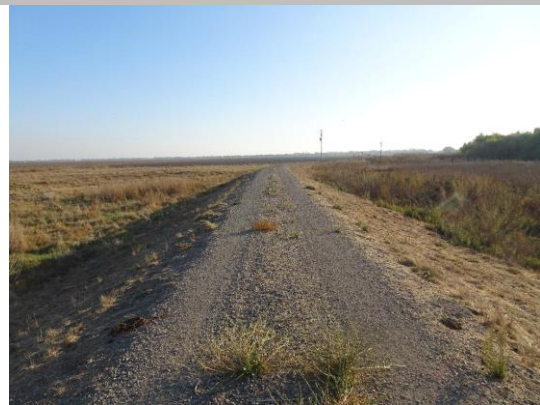
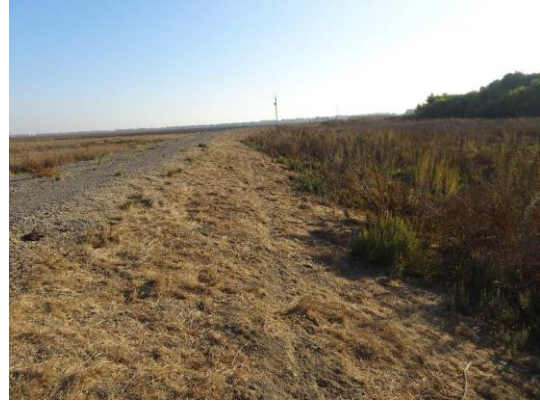
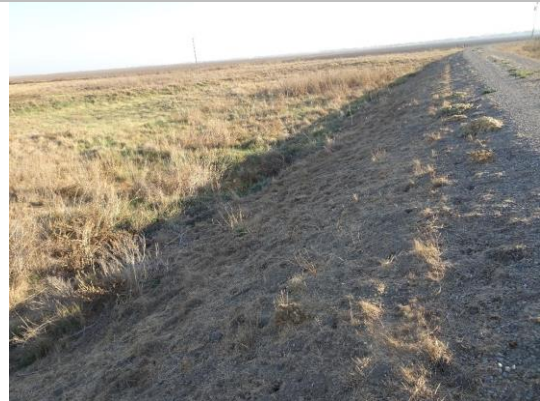
Photo 1 of 3 : UCIP_FA_2024_83273_90903.jpg

DS_ID:19598
FS_ID:83273
EP_NO: N/A
Repair Type: Non-Urgent
EVAL Issue: 5, Pipe Damage
Crossing Status: Found
UCIP Comments: 09/25/2024 DMP internal video inspection has found moderate pipe defects. Crossing will be monitored until funding becomes available for rehabilitation. (O. Yakimov - DWR UCIP) 11/16/2020 Record remains Non-Urgent. Limited access due to steep slopes. No permit was found authorizing this encroachment. CVFPB will need to review crossing to determine owner. DWR DMP internal inspection is pending and scheduled for 2021. (B. Singh - GEI, O. Magana - DWR UCIP) 04/25/2014 Recommend removing vegetation and sediment buildup from both waterward and landward concrete headwalls. (O. Magana - DWR UCIP)
FIELD_STRUCT_DESC: 24-inch corrugated metal (CM) gravity drainage pipe through the levee, 8.5 feet below the crown. Flap gate on the waterside (WS) end. Brass cap No. 40 bench mark (BM) on the headwall on the landside (LS). [Additional Reference(s): DWR Levee Log, 2002, (HLM 20.19). USACE San Joaquin O&M Manual, Unit No. 601, Part No. 1, (SJR601.1), 1967, Revised 25 May 2011, (HLM 20.18)].

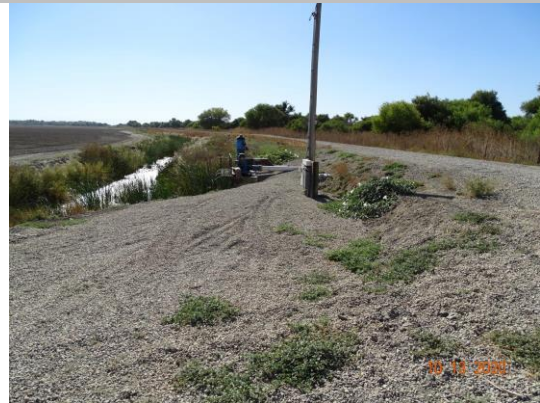
Photo 1 of 1 : FA_2024_NA0010_118_1184_20240828_00024.jpg

LM Start	20.25	Rating **	A/W	Issue No.	1184
LM End	20.25	Issue Type +	En	Location *	LS
Category	Earthen Levee			GPS Latitude/Longitude	
				Start	End
Item	Encroachments			37.193657 °	37.193657 °
				-120.760138 °	-120.760138 °
DWR ID	DWR_NA0010_01_s_2015_1184				
Comment Code					
RA : Ramp					
Inspector Comment					
Landowner installed unauthorized ramp on landside slope and toe.

Ramp cut into to the landside slope to access irrigation ditch at the landside toe. (Fall 2020)

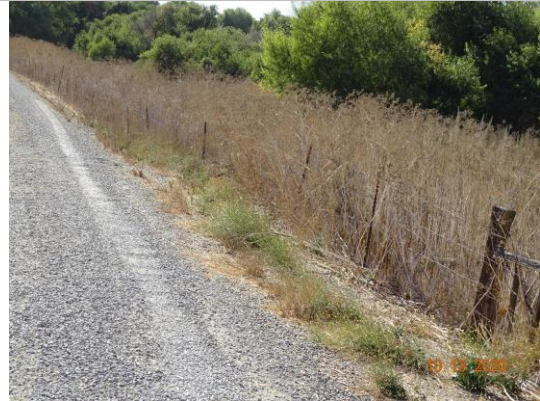
Photo 1 of 1 : FA_2024_NA0010_118_106_20240828_00009.jpg

LM Start	20.25	Rating **	A/W	Issue No.	106
LM End	22.51	Issue Type +	En	Location *	WS
Category	Earthen Levee			GPS Latitude/Longitude	
				Start	End
Item	Encroachments			37.193663 °	37.166957 °
				-120.760148 °	-120.750080 °
DWR ID	DWR_NA0010_01_f_2020_106				
Comment Code					
FE : Fence					
Inspector Comment					
Shown on as-builts

Barbed wire fence along the waterside slope. (Fall 2020)

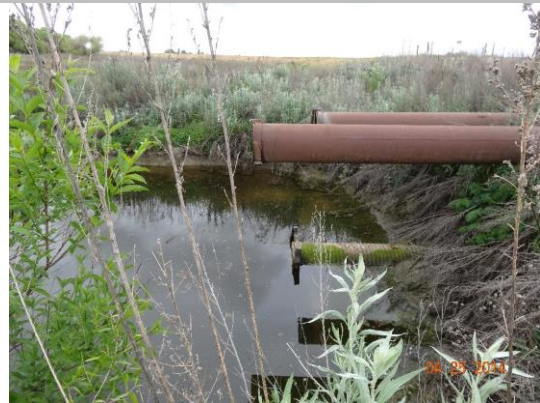
Photo 1 of 2 : UCIP_FA_2024_70721_66309.jpg

Comment Code						
Inspector Comment						
DS_ID:19600 FS_ID:70721 EP_NO: N/A Repair Type: Non-Urgent EVAL Issue: Crossing Status: Found UCIP Comments: 11/16/2020 Record remains Non-Urgent. Dense vegetation and fence on the WS prevented proper inspection of pipe. No permit has been found authorizing this pipe. CVFPB will need to review crossing to determine owner. (O. Magana - DWR UCIP) 04/25/2014 Crossing partially submersed--no signs of failure of pipe present along pipe alignment. Recommend contacting owner to determine status of crossing and condition. (O. Magana - DWR UCIP) FIELD_STRUCT_DESC: 36-inch corrugated metal (CM) gravity drainage pipe through the levee, 10.5 feet below the crown. Flap gate on the waterside (WS) end. Brass cap No. 40 bench mark (BM) on the headwall on the landside (LS). [Additional Reference(s): DWR Levee Log, 2002, (HLM 20.28). USACE San Joaquin O&M Manual, Unit No. 601, Part No. 1, (SJR601.1), 1967, Revised 25 May 2011, (HLM 20.27)]. FS Date: 11/6/2020

Multiple crossings visible on waterward side--36 inch CMP is submersed in water.

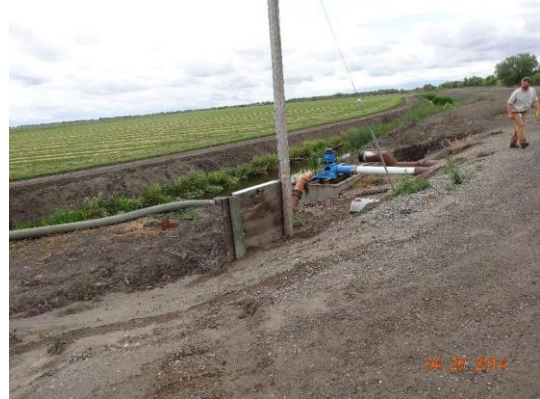
Photo 2 of 2 : UCIP_FA_2024_70721_66307.jpg

View of landward side.

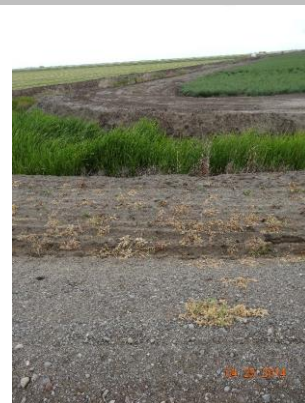
Photo 2 of 3 : UCIP_FA_2024_80999_66311.jpg

DS_ID:19603
FS_ID:80999
EP_NO: N/A
Repair Type: Urgent
EVAL Issue: 1, Pipe Integrity
Crossing Status: Found
UCIP Comments: 09/15/2023 Record updated from Non-Urgent to Urgent. DMP internal video inspection has found severe pipe defects. Crossing will be monitored until funding becomes available to address the issues. (O. Yakimov - DWR UCIP)
05/06/2021 Record remains Non-Urgent. This crossing appears to be non-functional based on the 2014 UCIP inspection. No field inspection has been completed by UCIP. DWR DMP internal inspection is pending and scheduled for 2021. Recommend having UCIP inspector or Levee inspector take current photos of the site. (O. Magana - DWR UCIP)
04/25/2014 Crossing is non-functional--crossing buried on landward side. Need to contact owner to determine status of crossing. If crossing is no longer used need to coordinate with CVFPB for proper abandonment. (O. Magana - DWR UCIP)

View of landward side.

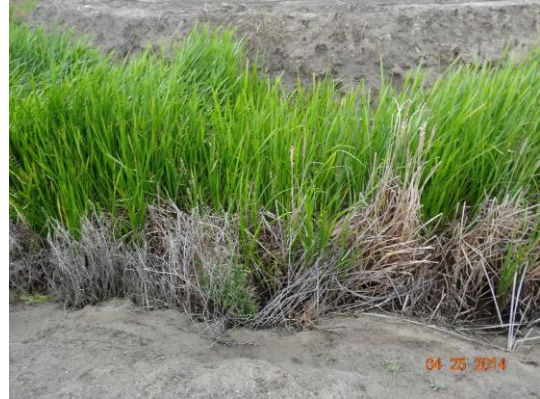
Photo 3 of 3 : UCIP_FA_2024_80999_66310.jpg

No signs of concrete headwall on landward toe.

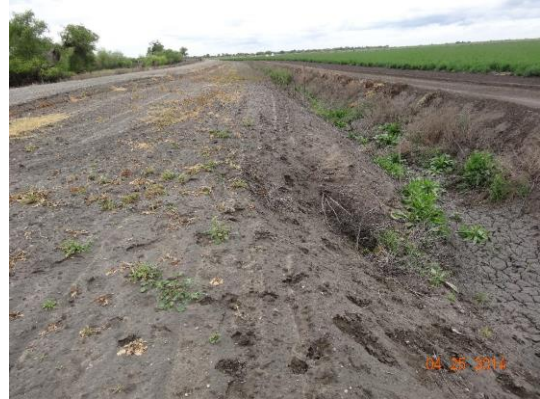
Photo 2 of 2 : UCIP_FA_2024_77848_65698.jpg

Comment Code						
Inspector Comment						
DS_ID:19604 FS_ID:77848 EP_NO: N/A Repair Type: Urgent EVAL Issue: 1, Pipe Integrity Crossing Status: Found UCIP Comments: 06/05/2024 Minor Alteration Work authorization No. WA2024094 issued for pipe replacement. Construction not yet started. (O. Yakimov - DWR UCIP) 12/14/2022 Record updated from Non-Urgent to Urgent. DMP internal video inspection has found pipe integrity issues. LOF of crossing is between 5 and 6. Crossing will be monitored until funding becomes available to address the issues. (O.Yakimov - DWR UCIP) 05/06/2021 Record remains Non-Urgent. This crossing appears to be non-functional based on the 2014 UCIP inspection. No field inspection has been completed by UCIP. DWR DMP internal inspection is pending and scheduled for 2021. Recommend having UCIP inspector or Levee inspector take current photos of the site. (O. Magana - DWR UCIP) 04/25/2014 Non-functional crossing-landward side is buried. Need to contact owner to determine status of crossing. If crossing is no longer used need to coordinate with CVFPB for proper abandonment. (O. Magana - DWR UCIP) FIELD_STRUCT_DESC: 24-inch corrugated metal (CM) gravity drainage pipe through the levee, 9.0 feet below the crown. Flap gate on the waterside (WS) end. Brass cap No. 40 bench mark (BM) on the headwall on the landside (LS). [Additional Reference(s): DWR Levee Log, 2002, (HLM 21.78). USACE San Joaquin O&M Manual, Unit No. 601, Part No. 1, (SJR601.1), 1967, Revised 25 May 2011, (HLM 21.76)]. FS Date: 5/6/2021 1:29:33 PM

Crossing not found on landward side. No signs on canal located on landward side.

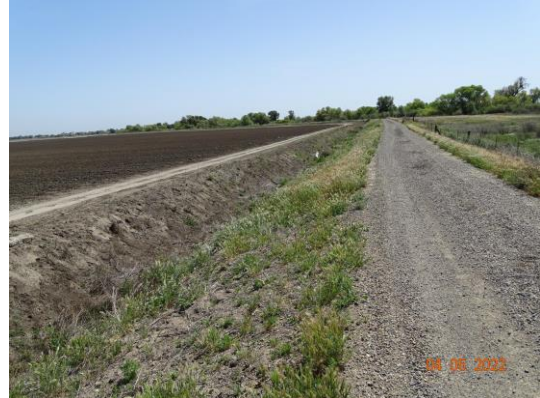
Photo 1 of 1 : FA_2024_NA0010_118_22_20240828_00004.jpg

LM Start	22.06	Rating **	A/W	Issue No.	22
LM End	22.52	Issue Type +	En	Location *	LS
Category	Earthen Levee			GPS Latitude/Longitude	
				Start	End
Item	Encroachments			37.172074 °	37.166906 °
				-120.754628 °	-120.749962 °
DWR ID	DWR_NA0010_01_s_2020_22				
Comment Code					
DT : Ditch					
Inspector Comment					
Ditch is permitted under CVFPB permit 3332

Looking upstream at irrigation at landside toe. (Spring 2022)

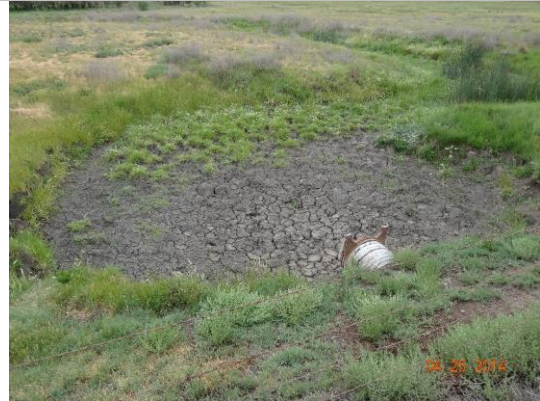
Photo 1 of 2 : UCIP_FA_2024_70729_65707.jpg

Comment Code						
Inspector Comment						
DS_ID:19605 FS_ID:70729 EP_NO: N/A Repair Type: Non-Urgent EVAL Issue: 5, Pipe Damage Crossing Status: Found UCIP Comments: 09/25/2024 DMP internal video inspection has found moderate pipe defects. Crossing will be monitored until funding becomes available for rehabilitation. (O. Yakimov - DWR UCIP) 05/06/2021 Record remains Non-Urgent. This crossing appears to be non-functional based on the 2014 UCIP inspection. No field inspection has been completed by UCIP. DWR DMP internal inspection is pending and scheduled for 2021. Recommend having UCIP inspector or Levee inspector take current photos of the site. (O. Magana - DWR UCIP) 04/25/2014 Non-functional crossing--landward side is buried. Need to contact owner to determine status. If crossing is no longer used need to coordinate with CVFPB for proper abandonment. (O. Magana - DWR UCIP) FIELD_STRUCT_DESC: 24-inch corrugated metal (CM) gravity drainage pipe through the levee, 9.0 feet below the crown. Flap gate on the waterside (WS) end. Wooden headboards on the landside (LS) end. Brass cap No. 31 bench mark (BM) on the headwall on the LS. [Additional Reference(s): DWR Levee Log, 2002, (HLM 22.13). USACE San Joaquin O&M Manual, Unit No. 601, Part No. 1, (SJR601.1), 1967, Revised 25 May 2011, (HLM 22.13)]. FS Date: 5/6/2021 9:50:00 AM

Flap gate visible on waterward side.

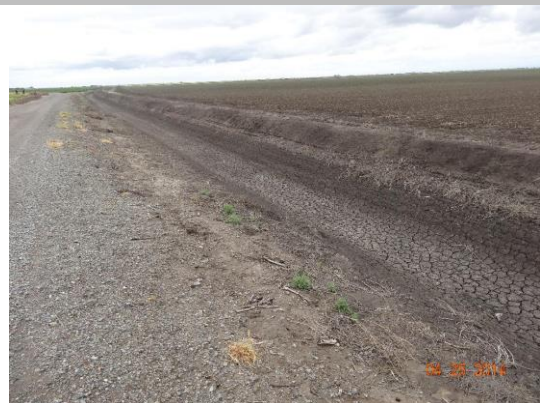
Photo 2 of 2 : UCIP_FA_2024_70729_65710.jpg

View of landward side.

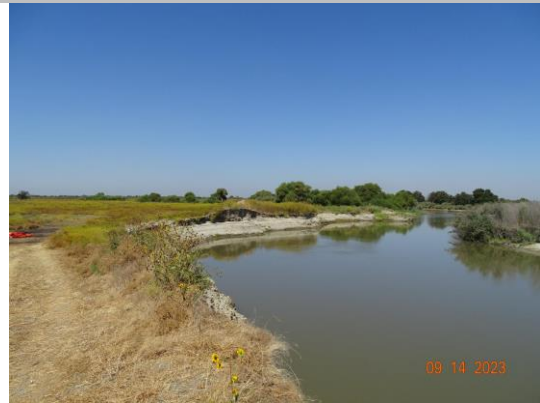
Photo 1 of 1 : FA_2024_NA0010_119_25_20240828_00003.jpg

LM Start	0.71	Rating **	A/W	Issue No.	25
LM End	0.76	Issue Type +	Ob	Location *	WS
Category	Earthen Levee			GPS Latitude/Longitude	
				Start	End
Item	Erosion / Bank Caving			37.287517 °	37.286800 °
				-120.874583 °	-120.874103 °
DWR ID	DWR_NA0010_02A_f_2023_25				
Comment Code					
E2 : Schedule repair of erosion site prior to the next inspection.					
Inspector Comment					
Site ID: NA0010U02ARM129.22 08/03/2022: From 2021 to present, no significant changes were observed during the annual survey. The length was extended to 300 ft. 08/20/2020: This site was discovered during the DWR Spring 2012 Levee Inspections. A 250-ft long levee section has completely eroded away and no longer provides adequate flood protection. Note: Unit 2A is in the process of being turned over to State Parks.

View of erosion through the levee crown looking downstream. (Fall 2023)

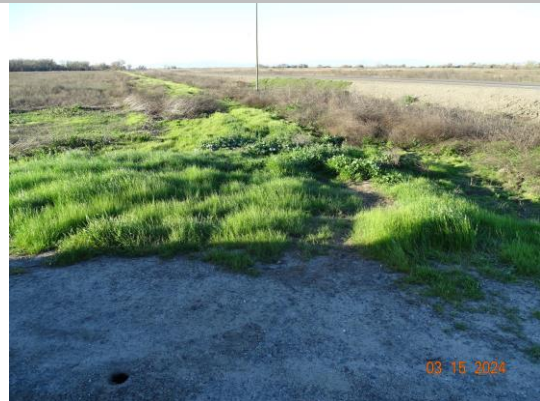
Photo 1 of 1 : FA_2024_NA0010_119_2_20240828_00001.jpg

LM Start	2.32	Rating **	M	Issue No.	2
LM End	2.32	Issue Type +	En	Location *	LS
Category	Earthen Levee			GPS Latitude/Longitude	
				Start	End
Item	Encroachments			37.291433 °	37.291433 °
				-120.850917 °	-120.850917 °
DWR ID	DWR_NA0010_02A_s _ 2012_2				
Comment Code					
RA : Ramp					
Inspector Comment					
Unauthorized ramps are located on the landside and waterside slopes.

View of unauthorized ramp on the landside slope. (Spring 2024)

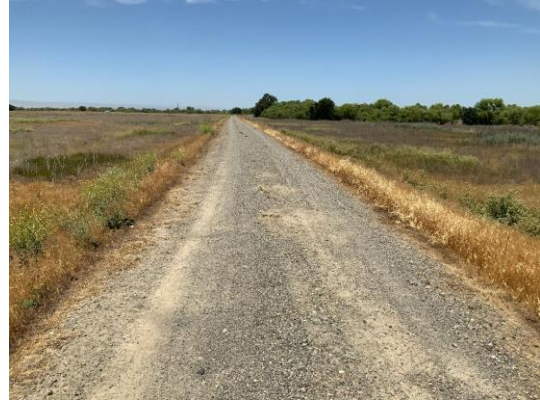
Photo 1 of 3 : UCIP_FA_2024_70942_100127.jpg

Comment Code						
Inspector Comment						
DS_ID:19661 FS_ID:70942 EP_NO: N/A Repair Type: Non-Urgent EVAL Issue: 5, Pipe Damage Crossing Status: Found UCIP Comments: 09/25/2024 DMP internal video inspection has found moderate pipe defects. Crossing will be monitored until funding becomes available for rehabilitation. (O. Yakimov - DWR UCIP) 06/8/2021 The record remains Non-Urgent. Vegetation on LS and WS limited close up inspection of flapgate and pipe inlet. No permit was found authorizing this encroachment. CVFPB will need to review crossing to determine owner. The UCIP inspection was completed with GEI staff, P. Espinoza. (H. Dunn ? GEI) 05/01/2014 Dense vegetation limits the inspector's visibility to identify signs of pipe failure (leaks) along the slope. Recommend removing vegetation along pipe alignment to conduct proper inspection of structure. (O. Magana - DWR UCIP) FIELD_STRUCT_DESC: 24-inch corrugated metal gravity drainage pipe (CMP) through the levee, 10.0 feet below the crown. Flap gate on the waterside (WS) end. Brass cap No. 130 bench mark (BM) on the headwall on the landside (LS). [Additional Reference(s): DWR Levee Log, 2002, (HLM 2.60). USACE San Joaquin O&M Manual, Unit No. 601, Part No. 1, 1967, Amended in 1978, Revised 20 June 1985, (HLM 2.59)]. FS Date: 6/8/2021

Levee crown looking downstream.

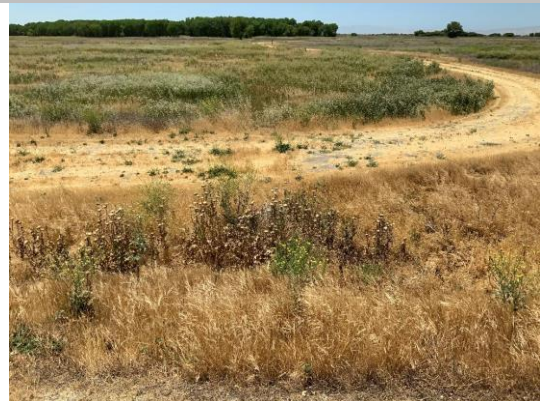
Photo 2 of 3 : UCIP_FA_2024_70942_100126.jpg

LS view: Toe from crown.

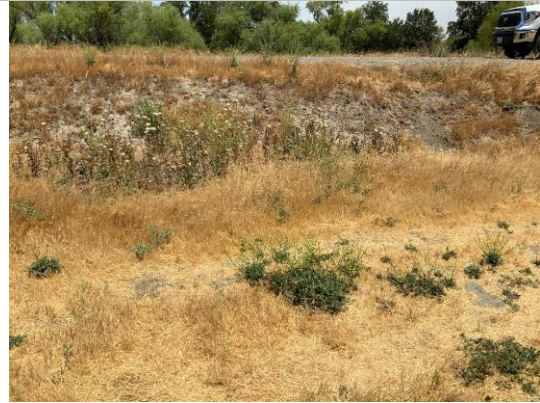
Photo 3 of 3 : UCIP_FA_2024_70942_100121.jpg

LS view: Slope from toe.

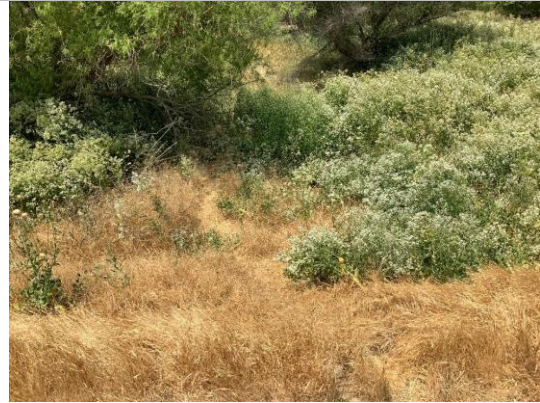
Photo 1 of 1 : UCIP_FA_2024_70944_100142.jpg

Comment Code						
Inspector Comment						
DS_ID:19665 FS_ID:70944 EP_NO: N/A Repair Type: Non-Urgent EVAL Issue: 5, Pipe Damage Crossing Status: Found UCIP Comments: 09/25/2024 DMP internal video inspection has found moderate pipe defects. Crossing will be monitored until funding becomes available for rehabilitation. (O. Yakimov - DWR UCIP) 06/7/2021 The record remains Non-Urgent. Dense vegetation limited view and inspection of LS pipe inlet. Recommend removal of LS vegetation. No permit was found authorizing this encroachment. CVFPB will need to review crossing to determine owner. The UCIP inspection was completed with GEI staff, P. Espinoza. (H. Dunn ? GEI) 05/01/2014 Dense vegetation limits the inspector's visibility to identify signs of pipe failure (leaks) along the slope. Recommend removing vegetation along pipe alignment to conduct proper inspection of structure. (O. Magana - DWR UCIP) FIELD_STRUCT_DESC: 24-inch corrugated metal gravity drainage pipe (CMP) through the levee, 12.4 feet below the crown. Flap gate on the waterside (WS) end. Brass cap No. 130 bench mark (BM) on the headwall on the landside (LS). [Additional Reference(s): DWR Levee Log, 2002, (HLM 3.31). USACE San Joaquin O&M Manual, Unit No. 601, Part No. 1, 1967, Amended in 1978, Revised 20 June 1985, (HLM 3.29)]. FS Date: 6/7/2021

LS view: Toe from crown, pipe end not visible.

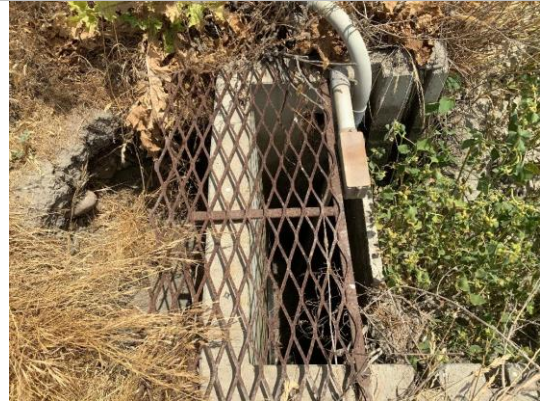
Photo 1 of 1 : UCIP_FA_2024_84503_100143.jpg

Comment Code						
Inspector Comment						
<p>DS_ID:19666 FS_ID:84503 EP_NO: N/A Repair Type: Urgent EVAL Issue: 1, Pipe Integrity Crossing Status: Found UCIP Comments: 07/12/2024 Record remains Urgent. Was informed by LSJLD that pipe appurtenances on LS have been removed. (M. Thao - DWR UCIP) 02/14/2022 Record updated from Non-Urgent to Urgent. DMP internal video inspection has found pipe integrity issues. LOF of crossing is between 5 and 6. Crossing will be monitored until funding becomes available to address the issues. (O. Yakimov - DWR UCIP)</p> <p>06/7/2021 The record remains Non-Urgent. LS has boards blocking the open pipe inlet but there is significant sediment and vegetation on the other side of the boards, recommend cleaning around. No permit was found authorizing this encroachment. CVFPB will need to review crossing to determine owner. The UCIP inspection was completed with GEI staff, P. Espinoza. (H. Dunn ? GEI) 05/01/2014 Dense vegetation limits the inspector's visibility to identify signs of pipe failure (leaks) along the slope. Recommend removing vegetation along pipe alignment to conduct proper inspection of structure. (O. Magana - DWR UCIP)</p> <p>FIELD_STRUCT_DESC: 24-inch corrugated metal gravity drainage pipe (CMP) through the levee, 10.0 feet below the crown. Flap gate on the waterside (WS) end. Brass cap No. 130 bench mark (BM) on the headwall on the landside (LS). [Additional Reference(s): DWR Levee Log, 2002, (HLM 3.63). USACE San Joaquin O&M Manual, Unit No. 601, Part No. 1, 1967, Amended in 1978, Revised 20 June 1985, (HLM 3.62)].</p> <p>FS Date: 6/7/2021 1:46:07 PM</p>

LS view: Close up of pipe inlet and headwall. Sediment behind boards blocking pipe inlet.

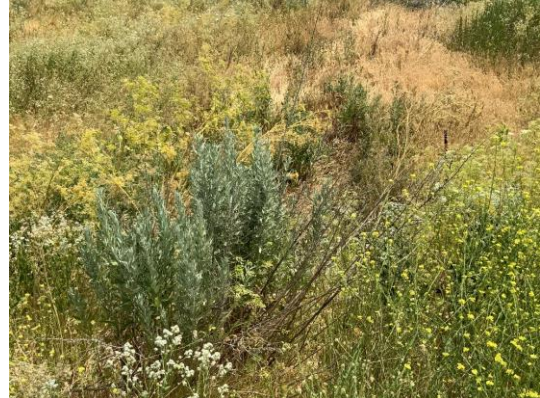
Photo 1 of 1 : UCIP_FA_2024_77860_100161.jpg

Comment Code						
Inspector Comment						
DS_ID:19668 FS_ID:77860 EP_NO: N/A Repair Type: Urgent EVAL Issue: 1, Pipe Integrity Crossing Status: Found UCIP Comments: 12/14/2022 Record updated from Non-Urgent to Urgent. DMP internal video inspection has found pipe integrity issues. LOF of crossing is between 5 and 6. Crossing will be monitored until funding becomes available to address the issues. (O.Yakimov - DWR UCIP) 06/7/2021 The record remains Non-Urgent. Limited inspection on WS due to dense vegetation, flapgate not visible, recommend clearing away. Limited insepction on LS due to canal limiting access to inlet. No permit was found authorizing this encroachment. CVFPB will need to review crossing to determine owner. The UCIP inspection was completed with GEI staff, P. Espinoza. (H. Dunn ? GEI)05/01/2014 Dense vegetation limits the inspector's visibility to identify signs of pipe failure (leaks) along the slope. Recommend removing vegetation along pipe alignment to conduct proper inspection of structure. (O. Magana - DWR UCIP) FIELD_STRUCT_DESC: 24-inch corrugated metal gravity drainage pipe (CMP) through the levee, 8.0 feet below the crown. Flap gate on the waterside (WS) end. Brass cap No. 125 bench mark (BM) on the headwall on the landside (LS). [Additional Reference(s): DWR Levee Log, 2002, (HLM 5.45). USACE San Joaquin O&M Manual, Unit No. 601, Part No. 1, 1967, Amended in 1978, Revised 20 June 1985, (HLM 5.43)]. FS Date: 6/7/2021 1:46:28 PM

WS view: Flapgate completely covered by vegetation at toe.

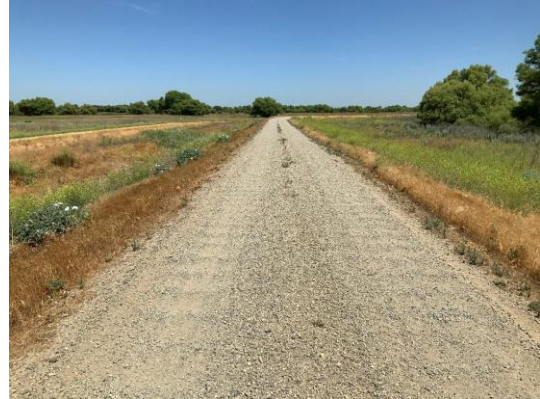
Photo 1 of 3 : UCIP_FA_2024_77862_100173.jpg

DS_ID:19670
FS_ID:77862
EP_NO: N/A
Repair Type: Urgent
EVAL Issue: 1, Pipe Integrity
Crossing Status: Found
UCIP Comments: 12/14/2022 Record updated from Non-Urgent to Urgent. DMP internal video inspection has found pipe integrity issues. LOF of crossing is between 5 and 6. Crossing will be monitored until funding becomes available to address the issues. (O.Yakimov - DWR UCIP)
06/7/2021 The record remains Non-Urgent. Limited inspection on LS due to canal and inability to access. No permit was found authorizing this encroachment. CVFPB will need to review crossing to determine owner. The UCIP inspection was completed with GEI staff, P. Espinoza. (H. Dunn ? GEI)05/01/2014 Dense vegetation limits the inspector's visibility to identify signs of pipe failure (leaks) along the slope. Recommend removing vegetation along pipe alignment to conduct proper inspection of structure. (O. Magana - DWR UCIP)
FIELD_STRUCT_DESC: 24-inch corrugated metal gravity drainage pipe (CMP) through the levee, 7.7 feet below the crown. Flap gate on the waterside (WS) end. Brass cap No. 125 bench mark (BM) on the headwall on the landside (LS). [Additional Reference(s): DWR Levee Log, 2002, (HLM 6.50). USACE San Joaquin O&M Manual, Unit No. 601, Part No. 1, 1967, Amended in 1978, Revised 20 June 1985, (HLM 6.50)].

Levee crown looking downstream.

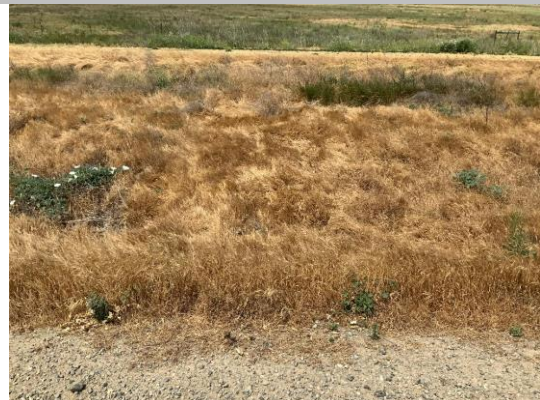
Photo 2 of 3 : UCIP_FA_2024_77862_100177.jpg

LS view: Toe from crown.

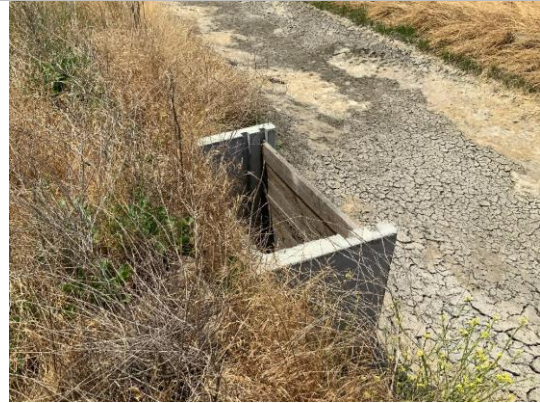
Photo 3 of 3 : UCIP_FA_2024_77862_100171.jpg

LS view: Close up of concrete box and pipe inlet.

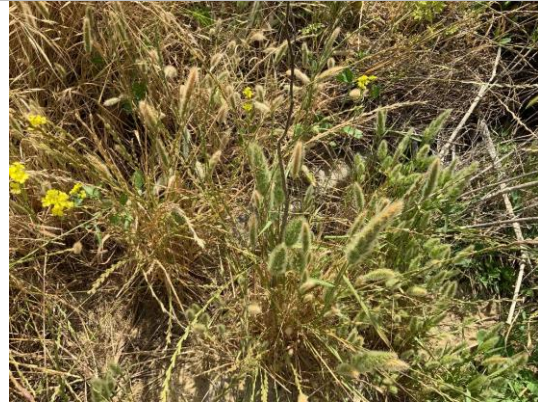
Photo 1 of 2 : UCIP_FA_2024_70950_100183.jpg

Comment Code						
Inspector Comment						
DS_ID:19671 FS_ID:70950 EP_NO: N/A Repair Type: Non-Urgent EVAL Issue: 5, Pipe Damage Crossing Status: Found UCIP Comments: 09/25/2024 DMP internal video inspection has found moderate pipe defects. Crossing will be monitored until funding becomes available for rehabilitation. (O. Yakimov - DWR UCIP) 06/7/2021 The record remains Non-Urgent. Dense vegetation on WS limited inspection. LS pipe inlet is completely buried under sediment, recommend cleaning out. No permit was found authorizing this encroachment. CVFPB will need to review crossing to determine owner. The UCIP inspection was completed with GEI staff, P. Espinoza. (H. Dunn ? GEI) 05/01/2014 Dense vegetation limits the inspector's visibility to identify signs of pipe failure (leaks) along the slope. Recommend removing vegetation along pipe alignment to conduct proper inspection of structure. Pipe extension visible on landward side--need to contact owner for additional information about extension/modification. (O. Magana - DWR UCIP) FIELD_STRUCT_DESC: 24-inch corrugated metal gravity drainage pipe (CMP) through the levee, 12.6 feet below the crown. Flap gate on the waterside (WS) end. Brass cap No. 125 bench mark (BM) on the headwall on the landside (LS). [Additional Reference(s): DWR Levee Log, 2002, (HLM 7.06). USACE San Joaquin O&M Manual, Unit No. 601, Part No. 1, 1967, Amended in 1978, Revised 20 June 1985, (HLM 7.05)]. FS Date: 6/7/2021

LS view: Headwall and inlet buried at toe.

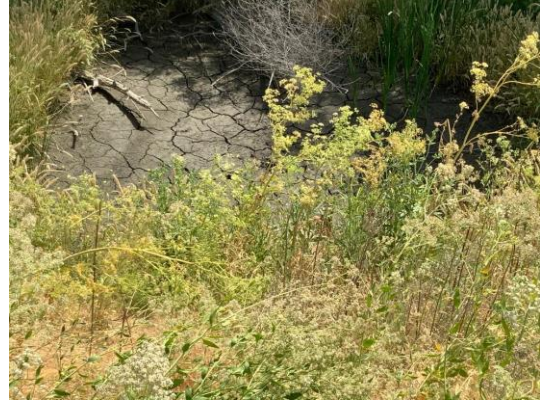
Photo 2 of 2 : UCIP_FA_2024_70950_100178.jpg

WS view: Flapgate barely visible at toe from slope.

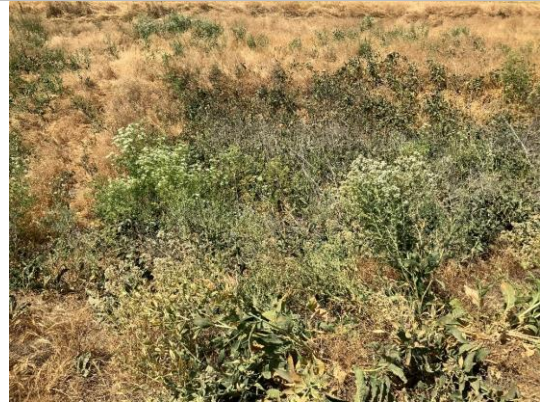
Photo 1 of 2 : UCIP_FA_2024_77863_100190.jpg

Comment Code						
Inspector Comment						
DS_ID:19673 FS_ID:77863 EP_NO: N/A Repair Type: Urgent EVAL Issue: 1, Pipe Integrity Crossing Status: Found UCIP Comments: 12/14/2022 Record updated from Non-Urgent to Urgent. DMP internal video inspection has found pipe integrity issues. LOF of crossing is between 5 and 6. Crossing will be monitored until funding becomes available to address the issues. (O.Yakimov - DWR UCIP) 06/7/2021 The record remains Non-Urgent. LS pipe end not visible, dense vegetation on both WS and LS ends, recommend removal. No permit was found authorizing this encroachment. CVFPB will need to review crossing to determine owner. The UCIP inspection was completed with GEI staff, P. Espinoza. (H. Dunn ? GEI) 05/01/2014 Dense vegetation limits the inspector's visibility to identify signs of pipe failure (leaks) along the slope. Recommend removing vegetation along pipe alignment to conduct proper inspection of structure. (O. Magana - DWR UCIP) FIELD_STRUCT_DESC: 24-inch corrugated metal gravity drainage pipe (CMP) through the levee, 8.0 feet below the crown. Flap gate on the waterside (WS) end. Brass cap No. 125 bench mark (BM) on the headwall on the landside (LS). [Additional Reference(s): DWR Levee Log, 2002, (HLM 7.78). USACE San Joaquin O&M Manual, Unit No. 601, Part No. 1, 1967, Amended in 1978, Revised 20 June 1985, (HLM 7.77)]. FS Date: 6/7/2021 1:49:23 PM

LS view: Headwall and inlet not visible under vegetation.

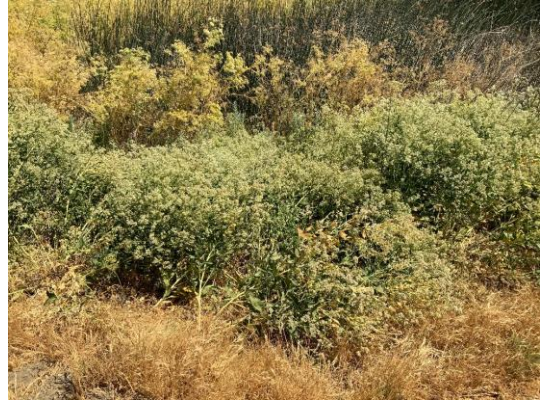
Photo 2 of 2 : UCIP_FA_2024_77863_100188.jpg

WS view: Toe from crown, flapgate covered in vegetation but just visible.

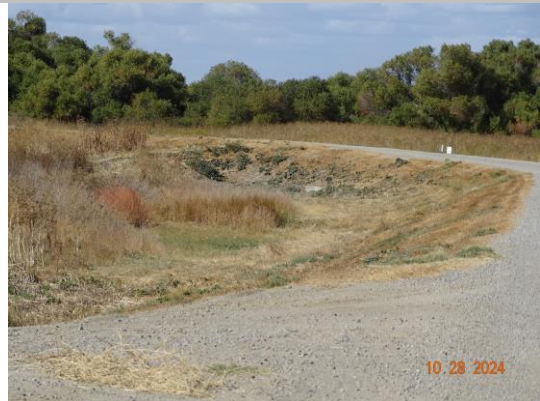
Photo 1 of 1 : FA_2024_NA0010_119_12_20241105_00021.jpg

LM Start	7.80	Rating **	A	Issue No.	12
LM End	7.80	Issue Type +	Ma	Location *	LS
Category	Earthen Levee			GPS Latitude/Longitude	
				Start	End
Item	Vegetation			37.231995 °	37.231995 °
				-120.812611 °	-120.812611 °
DWR ID	DWR_NA0010_02A_f_2024_12				
Comment Code					
V1 : Control annual grass and weeds on the levee slopes and easements.					
Inspector Comment

View of the landside slope looking downstream. (Fall 2024)

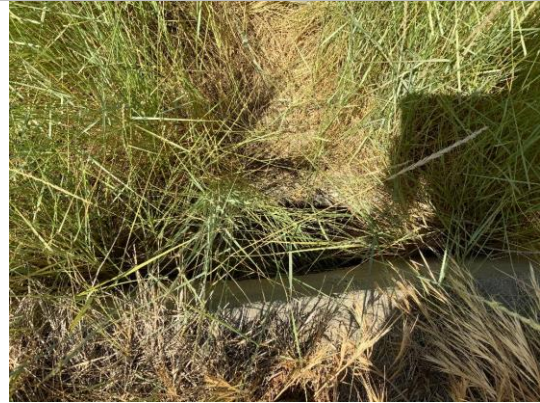
Photo 1 of 2 : UCIP_FA_2024_83302_100043.jpg

Comment Code						
Inspector Comment						
DS_ID:19674 FS_ID:83302 EP_NO: N/A Repair Type: Non-Urgent EVAL Issue: Crossing Status: Found UCIP Comments: 06/7/2021 Record remains Non-Urgent. DWR DMP internal inspection has not found pipe integrity issues. LOF of crossing is less or equal to 4.0. Recommend next video inspection in 5 years. LS headwall barely visible at toe due to dense vegetation. Dense vegetation also over WS flapgate. Limited inspection of both WS and LS pipe ends. Recommend removal of vegetation on both WS and LS. No permit was found authorizing this encroachment. CVFPB will need to review crossing to determine owner. The UCIP inspection was completed with GEI staff, P. Espinoza. (H. Dunn ? GEI)05/14/2014 Dense vegetation limits the inspector's visibility to identify signs of pipe failure (leaks) along the slope and landward headwall. Recommend removing vegetation along pipe alignment and toe to conduct proper inspection of structure. Sediment buildup in pipe visible from landward side--recommend clearing. (O. Magana - DWR UCIP) FIELD_STRUCT_DESC: 24-inch corrugated metal gravity drainage pipe (CMP) through the levee, 9.0 feet below the crown. Flap gate on the waterside (WS) end. Brass cap No. 120 bench mark (BM) on the headwall on the landside (LS). [Additional Reference(s): DWR Levee Log, 2002, (HLM 8.17). USACE San Joaquin O&M Manual, Unit No. 601, Part No. 1, 1967, Amended in 1978, Revised 20 June 1985, (HLM 8.16)]. FS Date: 6/7/2021

LS view: Headwall barely visible at toe.

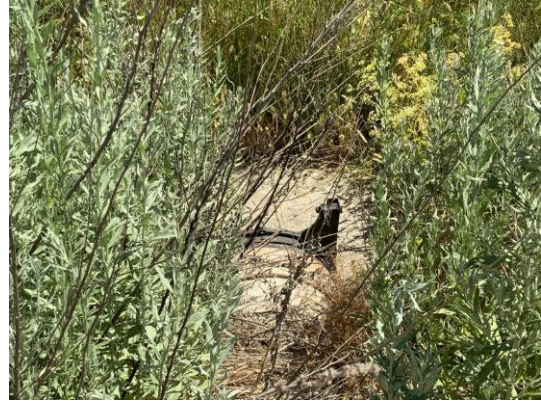
Photo 2 of 2 : UCIP_FA_2024_83302_100046.jpg

WS view: Flapgate visible at toe.

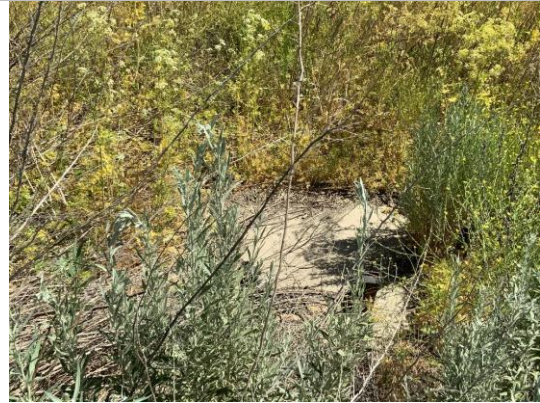
Photo 2 of 2 : UCIP_FA_2024_70954_100338.jpg

DS_ID:19675
FS_ID:70954
EP_NO: N/A
Repair Type: Non-Urgent
EVAL Issue: 11, Maintenance Compliance Issue
Crossing Status: Found
UCIP Comments: 06/7/2021 The record remains Non-Urgent. LS pipe inlet completely buried in dense vegetation, only top of headwall visible. Dense vegetation above WS flapgate. Limited inspection of pipe ends, recommend vegetation removal on both sides. No permit was found authorizing this encroachment. CVFPB will need to review crossing to determine owner. The UCIP inspection was completed with GEI staff, P. Espinoza. (H. Dunn ? GEI)05/14/2014 Dense vegetation on landward toe. Also dense vegetation limits the inspector's visibility to identify signs of pipe failure (leaks) along waterward slope. Recommend removing vegetation along pipe alignment toe to conduct proper inspection of structure. Sediment buildup in pipe--recommend clearing. (O. Magana - DWR UCIP)
FIELD_STRUCT_DESC: 24-inch corrugated metal gravity drainage pipe (CMP) through the levee, 9.4 feet below the crown. Flap gate on the waterside (WS) end. Brass cap No. 120 bench mark (BM) on the headwall on the landside (LS). [Additional Reference(s): DWR Levee Log, 2002, (HLM 8.49). USACE San Joaquin O&M Manual, Unit No. 601, Part No. 1, 1967, Amended in 1978, Revised 20 June 1985, (HLM 8.48)].

WS view: Top of flapgate visible at toe.

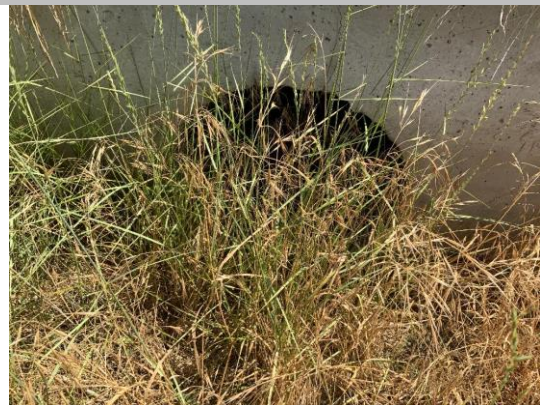
Photo 1 of 1 : UCIP_FA_2024_70955_100350.jpg

DS_ID:19676
FS_ID:70955
EP_NO: N/A
Repair Type: Non-Urgent
EVAL Issue: 11, Maintenance Compliance Issue
Crossing Status: Found
UCIP Comments: 06/7/2021 The record remains Non-Urgent. DWR DMP internal inspection has not found pipe integrity issues. LOF of crossing is less or equal to 4.0. Recommend next video inspection in 5 years. Dense vegetation around LS pipe end, recommend removal. No permit was found authorizing this encroachment. CVFPB will need to review crossing to determine owner. The UCIP inspection was completed with GEI staff, P. Espinoza. (H. Dunn ? GEI)05/14/2014
Dense vegetation limits the inspector's visibility to identify signs of pipe failure (leaks) along the slope. Recommend removing vegetation along pipe alignment to conduct proper inspection of structure. Burrow activity present on waterward slope. (O. Magana - DWR UCIP)
FIELD_STRUCT_DESC: 24-inch corrugated metal gravity drainage pipe (CMP) through the levee, 8.8 feet below the crown. Flap gate on the waterside (WS) end. Brass cap No. 120 bench mark (BM) on the headwall on the landside (LS). [Additional Reference(s): DWR Levee Log, 2002, (HLM 8.88). USACE San Joaquin O&M Manual, Unit No. 601, Part No. 1, 1967, Amended in 1978, Revised 20 June 1985, (recorded as HLM 9.86, should be HLM 8.86)].

LS view: Close up of pipe inlet at toe.

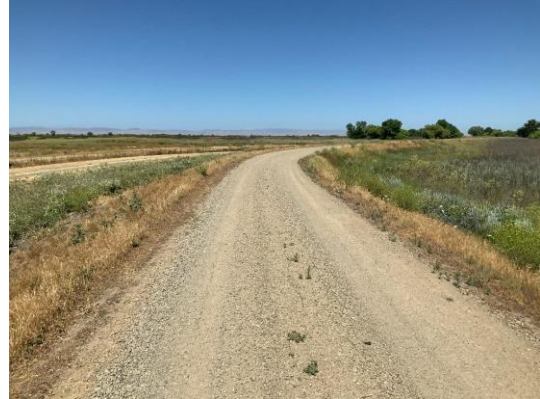
Photo 1 of 3 : UCIP_FA_2024_83303_100353.jpg

Levee crown looking downstream.

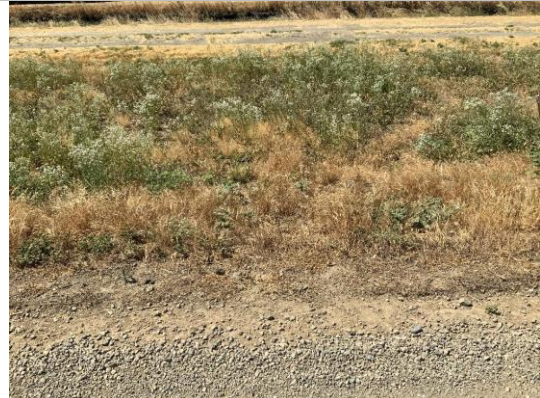
Photo 2 of 3 : UCIP_FA_2024_83303_100354.jpg

LS view: Toe from crown.

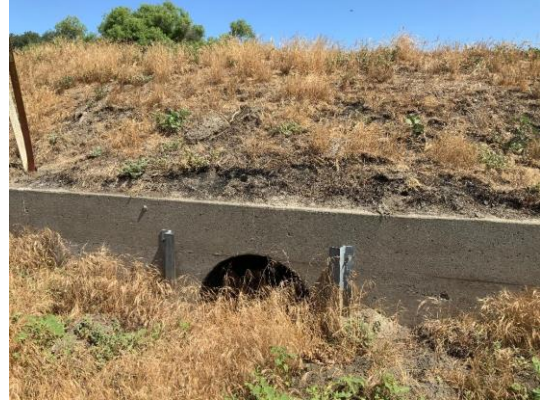
Photo 3 of 3 : UCIP_FA_2024_83303_100355.jpg

LS view: Slope and headwall at toe.

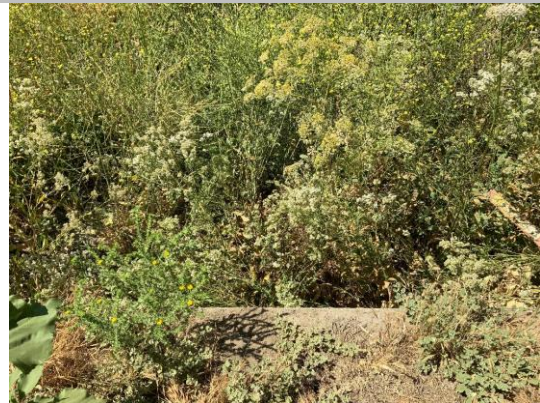
Photo 1 of 1 : UCIP_FA_2024_70957_100363.jpg

DS_ID:19678
FS_ID:70957
EP_NO: N/A
Repair Type: Non-Urgent
EVAL Issue: 11, Maintenance Compliance Issue
Crossing Status: Found
UCIP Comments: 06/7/2021 The record remains Non-Urgent. DWR DMP internal inspection has not found pipe integrity issues. LOF of crossing is less or equal to 4.0. Recommend next video inspection in 5 years. Dense vegetation over LS pipe inlet limited inspection, recommend removal. No permit was found authorizing this encroachment. CVFPB will need to review crossing to determine owner. The UCIP inspection was completed with GEI staff, P. Espinoza. (H. Dunn ? GEI)05/14/2014 Dense vegetation limits the inspector's visibility to identify signs of pipe failure (leaks) along the slope. Recommend removing vegetation along pipe alignment to conduct proper inspection of structure. (O. Magana - DWR UCIP)
FIELD_STRUCT_DESC: 24-inch corrugated metal gravity drainage pipe (CMP) through the levee, 8.0 feet below the crown. Flap gate on the waterside (WS) end. Brass cap No. 120 bench mark (BM) on the headwall on the landside (LS). [Additional Reference(s): DWR Levee Log, 2002, (HLM 9.21). USACE San Joaquin O&M Manual, Unit No. 601, Part No. 1, 1967, Amended in 1978, Revised 20 June 1985, (HLM 9.20)].

LS view: Top of headwall visible, pipe inlet covered with dense vegetation.

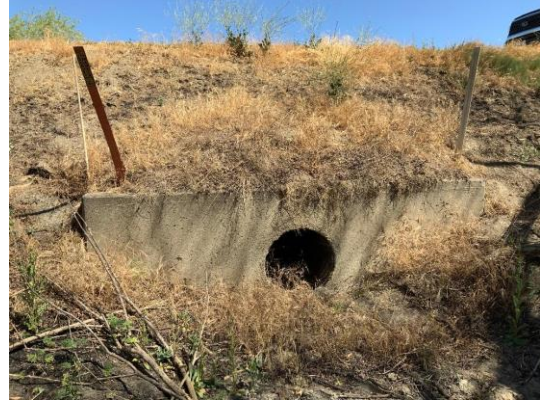
Photo 1 of 2 : UCIP_FA_2024_83304_100371.jpg

Comment Code						
Inspector Comment						
DS_ID:19686 FS_ID:83304 EP_NO: N/A Repair Type: No Action Needed EVAL Issue: Crossing Status: Found UCIP Comments: 04/25/2024 Record updated from Non-Urgent to No Action Needed. DMP internal video inspection has found none or minor pipe defects. (M. Thao - DWR UCIP) 12/20/2022 Record updated from Urgent to Non-Urgent. Pipe has been CIPP-lined. LOF of crossing is less or equal to 4. Recommend next video inspection in 5 years. (O. Yakimov - DWR UCIP) 06/07/2021 The record has been upgraded from Non-Urgent to Urgent. DWR DMP internal inspection has found pipe integrity issues. LOF of crossing is greater than or equal to 5.0. Crossing will be monitored until funding becomes available to address the issues. Some rusting and peeling of liner inside LS pipe inlet. No permit was found authorizing this encroachment. CVFPB will need to review crossing to determine owner. The UCIP inspection was completed with GEI staff, P. Espinoza. (H. Dunn - GEI) 05/14/2014 Dense vegetation limits the inspector's visibility to identify signs of pipe failure (leaks) along the slope. Recommend removing vegetation along pipe alignment to conduct proper inspection of structure. (O. Magana - DWR UCIP) FIELD_STRUCT_DESC: 24-inch CIPP-lined corrugated metal gravity drainage pipe (CMP) through the levee, 9.0 feet below the crown. Flap gate on the waterside (WS) end. Brass cap No. 115 bench mark (BM) on the headwall on the landside (LS). [Additional Reference(s): DWR Levee Log, 2002, (HLM 9.47). USACE San Joaquin O&M Manual, Unit No. 601, Part No. 1, 1967, Amended in 1978, Revised 20 June 1985, (HLM 9.46)]. FS Date: 12/20/2022 9:08:29 AM

LS view: Slope and headwall at toe.

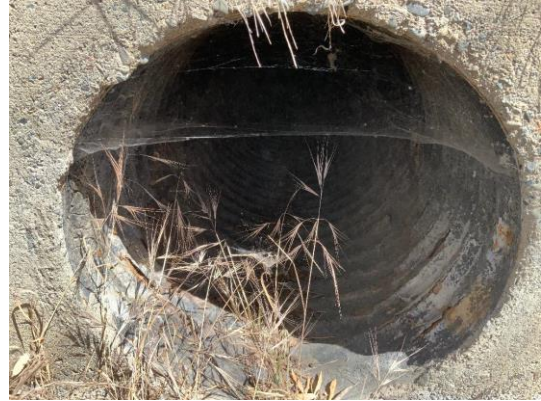
Photo 2 of 2 : UCIP_FA_2024_83304_100372.jpg

LS view: Close up of pipe inlet at toe.

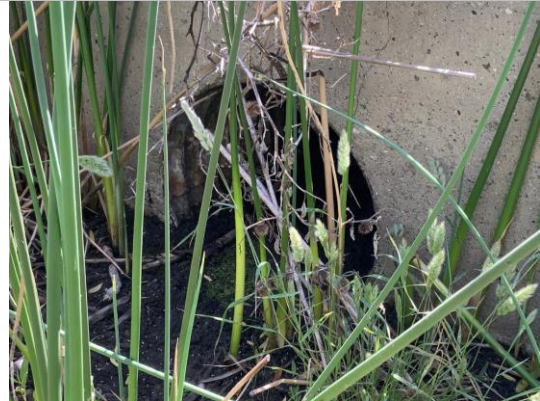
Photo 1 of 2 : UCIP_FA_2024_70959_100379.jpg

DS_ID:19687
FS_ID:70959
EP_NO: N/A
Repair Type: Non-Urgent
EVAL Issue: 11, Maintenance Compliance Issue
Crossing Status: Found
UCIP Comments: 06/7/2021 The record remains Non-Urgent. Some sediment buildup inside LS pipe inlet. LS pipe inlet also covered by some vegetation. Recommend cleaning out sediment and removing vegetation. WS flapgate partially underwater and covered by vegetation, limited inspection of both WS and LS. No permit was found authorizing this encroachment. CVFPB will need to review crossing to determine owner. The UCIP inspection was completed with GEI staff, P. Espinoza. (H. Dunn- GEI) 05/14/2014 Dense vegetation limits the inspector's visibility to identify signs of pipe failure (leaks) along the slope. Recommend removing vegetation along pipe alignment to conduct proper inspection of structure. (O. Magana - DWR UCIP)
FIELD_STRUCT_DESC: 24-inch corrugated metal gravity drainage pipe (CMP) through the levee, 11.7 feet below the crown. Flap gate on the waterside (WS) end. Brass cap No. 115 bench mark (BM) on the headwall on the landside (LS). [Additional Reference(s): DWR Levee Log, 2002, (HLM 10.13). USACE San Joaquin O&M Manual, Unit No. 601, Part No. 1, 1967, Amended in 1978, Revised 20 June 1985, (HLM 10.12)].

LS view: Close up of pipe inlet at toe, sediment built up.

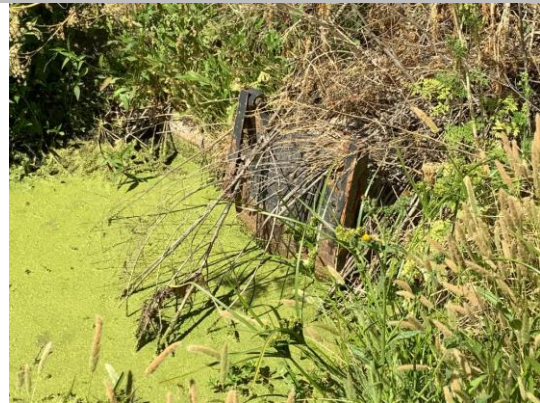
Photo 2 of 2 : UCIP_FA_2024_70959_100374.jpg

WS view: Close up of flapgate partially underwater at toe.
