Flood Control Project Maintenance Levee Inspections

Fall 2024 Levee Maintenance Deficiency Summary Report

San Joaquin River Basin

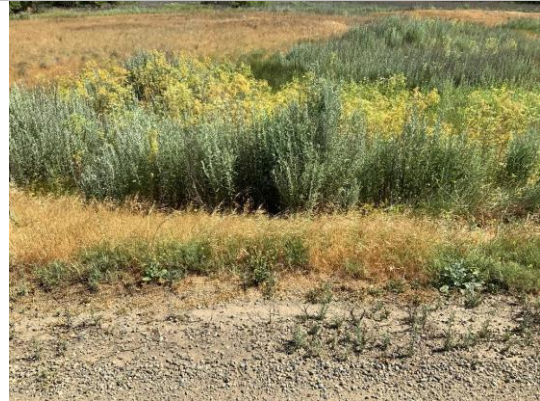
Photo 1 of 2 : UCIP_FA_2024_70960_100381.jpg

Comment Code						
Inspector Comment						
DS_ID:19688						
FS_ID:70960						
EP_NO: N/A						
Repair Type: Non-Urgent						
EVAL Issue: 11, Maintenance Compliance Issue						
Crossing Status: Found						
UCIP Comments: 06/7/2021 The record remains Non-Urgent. WS end and flapgate is overgrown with dense vegetation limiting inspection, recommend removal. No permit was found authorizing this encroachment. CVFPB will need to review crossing to determine owner. The UCIP inspection was completed with GEI staff, P. Espinoza. (H. Dunn ? GEI)05/14/2014 Dense vegetation limits the inspector's visibility to identify signs of pipe failure (leaks) along the slope. Recommend removing vegetation along pipe alignment to conduct proper inspection of structure. Sediment buildup in pipe visible on landward side--recommend clearing. (O. Magana - DWR UCIP)						
FIELD_STRUCT_DESC: 24-inch corrugated metal gravity drainage pipe (CMP) through the levee, 8.0 feet below the crown. Flap gate on the waterside (WS) end. Brass cap No. 115 bench mark (BM) on the headwall on the landside (LS). [Additional Reference(s): DWR Levee Log, 2002, (HLM 10.82). USACE San Joaquin O&M Manual, Unit No. 601, Part No. 1, 1967, Amended in 1978, Revised 20 June 1985, (HLM 10.81)].

WS view: Toe from crown.

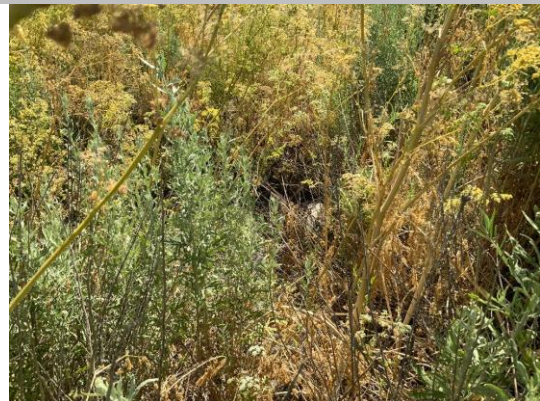
Photo 2 of 2 : UCIP_FA_2024_70960_100382.jpg

WS view: Dense vegetation covering flapgate at toe.

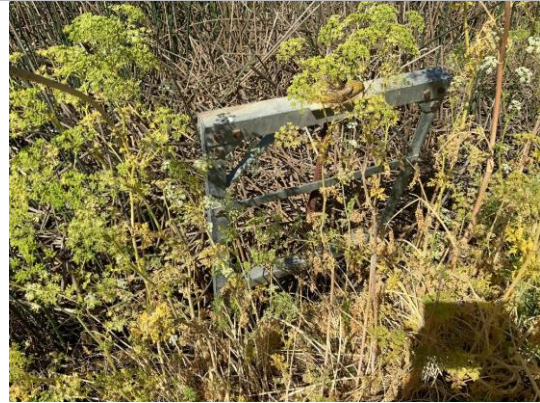
Photo 1 of 1 : UCIP_FA_2024_70961_100390.jpg

Comment Code						
Inspector Comment						
DS_ID:19689 FS_ID:70961 EP_NO: N/A Repair Type: Non-Urgent EVAL Issue: 5, Pipe Damage Crossing Status: Found UCIP Comments: 09/25/2024 DMP internal video inspection has found moderate pipe defects. Crossing will be monitored until funding becomes available for rehabilitation. (O. Yakimov - DWR UCIP) 06/7/2021 The record remains Non-Urgent. Dense vegetation covering LS pipe inlet limiting inspection, recommend removal. No permit was found authorizing this encroachment. CVFPB will need to review crossing to determine owner. The UCIP inspection was completed with GEI staff, P. Espinoza. (H. Dunn- GEI)05/14/201 Dense vegetation limits the inspector's visibility to identify signs of pipe failure (leaks) along the slope. Recommend removing vegetation along pipe alignment to conduct proper inspection of structure. (O. Magana - DWR UCIP) FIELD_STRUCT_DESC: 24-inch corrugated metal gravity drainage pipe (CMP) through the levee, 8.0 feet below the crown. Flap gate on the waterside (WS) end. Brass cap No. 115 bench mark (BM) on the headwall on the landside (LS). [Additional Reference(s): DWR Levee Log, 2002, (HLM 11.18). USACE San Joaquin O&M Manual, Unit No. 601, Part No. 1, 1967, Amended in 1978, Revised 20 June 1985, (HLM 11.17)]. FS Date: 6/7/2021

LS view: Headwall barely visible at toe, inlet covered in vegetation.

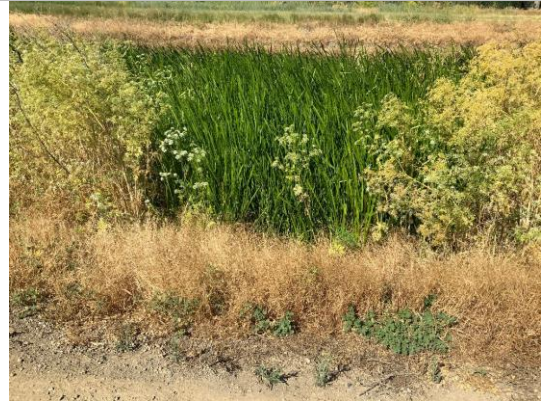
Photo 1 of 2 : UCIP_FA_2024_70962_100395.jpg

Comment Code						
Inspector Comment						
DS_ID:19690 FS_ID:70962 EP_NO: N/A Repair Type: Non-Urgent EVAL Issue: 5, Pipe Damage Crossing Status: Found UCIP Comments: 09/25/2024 DMP internal video inspection has found moderate pipe defects. Crossing will be monitored until funding becomes available for rehabilitation. (O. Yakimov - DWR UCIP) 06/7/2021 The record remains Non-Urgent. Dense vegetation over LS end, cannot see pipe inlet, recommend vegetation removal. WS flapgate has some vegetation covering it, recommend clearing. No permit was found authorizing this encroachment. CVFPB will need to review crossing to determine owner. The UCIP inspection was completed with GEI staff, P. Espinoza. (H. Dunn ? GEI)05/14/2014 Dense vegetation limits the inspector's visibility to identify signs of pipe failure (leaks) along the slope. Recommend removing vegetation along pipe alignment to conduct proper inspection of structure. (O. Magana - DWR UCIP) FIELD_STRUCT_DESC: 24-inch corrugated metal gravity drainage pipe (CMP) through the levee, 8.0 feet below the crown. Flap gate on the waterside (WS) end. Screw gate on the landside (LS). [Additional Reference(s): DWR Levee Log, 2002, (HLM 11.45). USACE San Joaquin O&M Manual, Unit No. 601, Part No. 1, 1967, Amended in 1978, Revised 20 June 1985, (HLM 11.43)]. FS Date: 6/7/2021

LS view: Toe from crown, dense vegetation, no pipe visible.

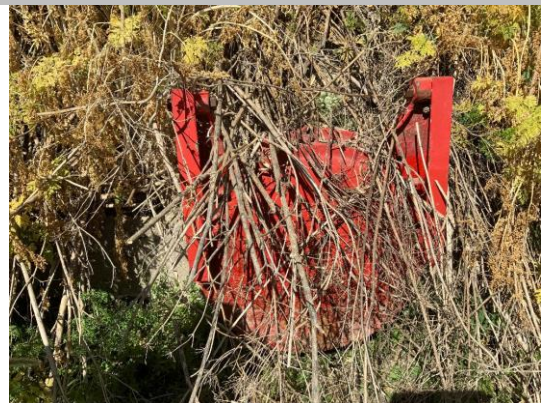
Photo 2 of 2 : UCIP_FA_2024_70962_100398.jpg

WS view: Close up of flapgate at toe.

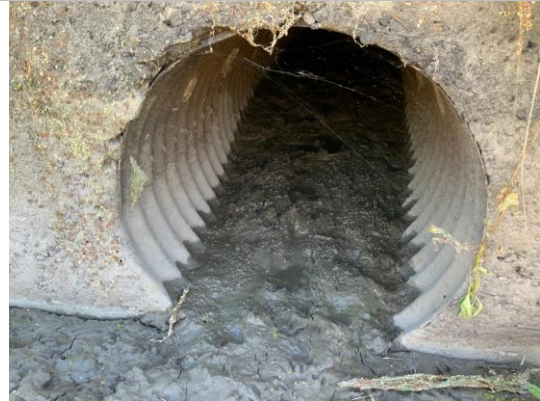
Photo 1 of 2 : UCIP_FA_2024_70963_100404.jpg

DS_ID:19663
FS_ID:70963
EP_NO: N/A
Repair Type: Non-Urgent
EVAL Issue: 11, Maintenance Compliance Issue
Crossing Status: Found
UCIP Comments: 06/7/2021 The record remains Non-Urgent. Sediment buildup inside LS pipe inlet, recommend cleaning out. Dense vegetation over WS end limited inspection, recommend removal. No permit was found authorizing this encroachment. CVFPB will need to review crossing to determine owner. The UCIP inspection was completed with GEI staff, P. Espinoza. (H. Dunn - GEI)05/14/201 Dense vegetation limits the inspector's visibility to identify signs of pipe failure (leaks) along the slope. Recommend removing vegetation along pipe alignment to conduct proper inspection of structure. Sediment buildup in pipe-- recommend clearing. (O. Magana - DWR UCIP)
FIELD_STRUCT_DESC: 24-inch corrugated metal gravity drainage pipe (CMP) through the levee, 6.5 feet below the crown. Slide gate in a pipe riser unit on the waterside (WS) slope. [Additional Reference(s): DWR Levee Log, 2002, (HLM 13.23). USACE San Joaquin O&M Manual, Unit No. 601, Part No. 1, 1967, Amended in 1978, Revised 20 June 1985, (HLM 13.22)].

LS view: Close up of pipe inlet at toe, sediment buildup.

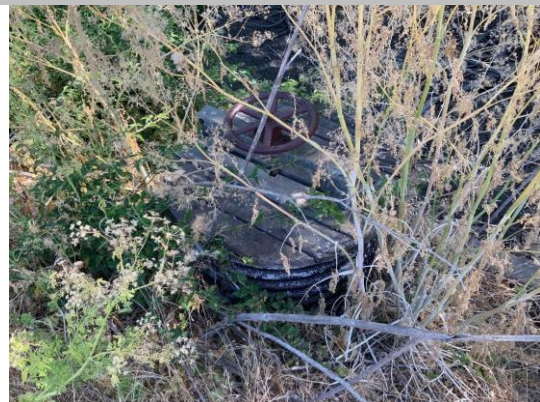
Photo 2 of 2 : UCIP_FA_2024_70963_100399.jpg

WS view: Close up of riser with slidegate on slope.

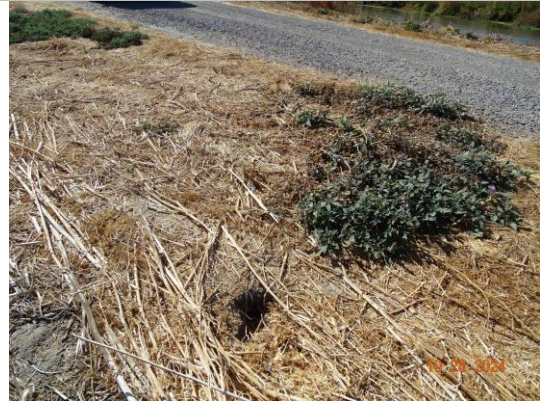
Photo 1 of 1 : FA_2024_NA0010_120_22_20241105_00023.jpg

LM Start	13.73	Rating **	M	Issue No.	22
LM End	13.73	Issue Type +	Ma	Location *	WS
Category	Earthen Levee			GPS Latitude/Longitude	
				Start	End
Item	Animal Control			37.172387°	37.172387°
				-120.761190°	-120.761190°
DWR ID	DWR_NA0010_02B_f_2018_22				
Comment Code					
A1 : Exterminate rodents and backfill and compact or grout burrows.					
Inspector Comment					
There are several rodent burrows observed at this location.

View of representative rodent burrow on the waterside slope. (Fall 2024)

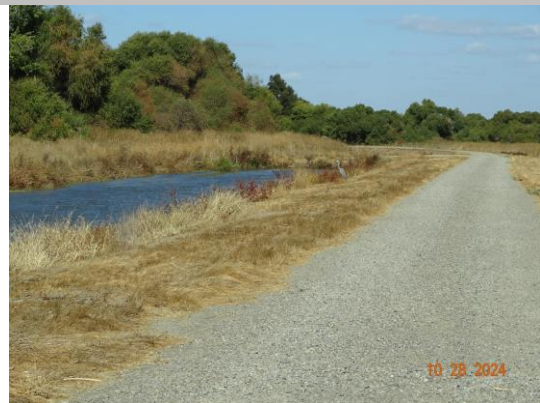
Photo 1 of 1 : FA_2024_NA0010_120_12_20241105_00024.jpg

LM Start	13.74	Rating **	A	Issue No.	12
LM End	13.74	Issue Type +	Ma	Location *	LS
Category	Earthen Levee			GPS Latitude/Longitude	
				Start	End
Item	Vegetation			37.172290 °	37.172290 °
				-120.761189 °	-120.761189 °
DWR ID	DWR_NA0010_02B_f_2024_12				
Comment Code					
V1 : Control annual grass and weeds on the levee slopes and easements.					
Inspector Comment

View of vegetation management on the landside slope. (Fall 2024)

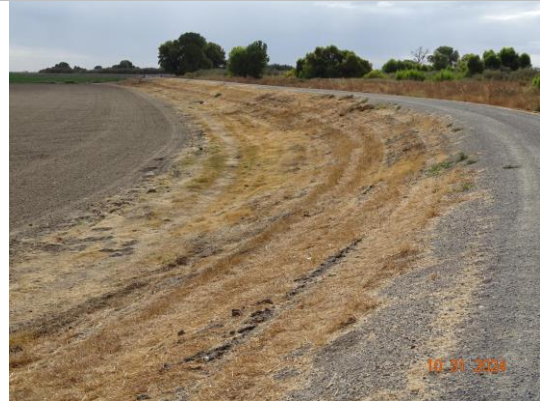
Photo 1 of 1 : FA_2024_NA0010_121_7_20241105_00018.jpg

LM Start	0.24	Rating **	A	Issue No.	7
LM End	0.24	Issue Type +	Ma	Location *	LS
Category	Earthen Levee			GPS Latitude/Longitude	
				Start	End
Item	Vegetation			37.108320°	37.108320°
				-120.587736°	-120.587736°
DWR ID	DWR_NA0010_03_f_2024_7				
Comment Code					
V1 : Control annual grass and weeds on the levee slopes and easements.					
Inspector Comment

View of the vegetation management on the landside slope. (Fall 2024)

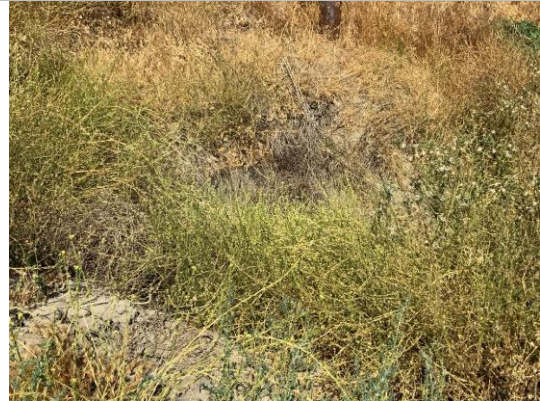
Photo 1 of 1 : UCIP_FA_2024_70965_101342.jpg

Comment Code					
Inspector Comment					
DS_ID:19691 FS_ID:70965 EP_NO: N/A Repair Type: Non-Urgent EVAL Issue: 11, Maintenance Compliance Issue Crossing Status: Found UCIP Comments: 07/12/2021 The record remains Non-Urgent. Dense vegetation over LS pipe inlet, headwall just barely visible, recommend removal. No permit was found authorizing this encroachment. CVFPB will need to review crossing to determine owner. The UCIP inspection was completed with GEI staff, P. Espinoza. (H. Dunn ? GEI) 04/17/2014 Need to contact owner. Recommend removing tall grass on landward slope and clearing sediment build up inside pipe. (O. Magana - DWR UCIP) FIELD_STRUCT_DESC: 24-inch corrugated metal gravity drainage pipe (CMP) through the levee, 11.3 feet below the crown. Flap gate on the waterside (WS) end. [Additional Reference(s): DWR Levee Log, 2002, (HLM 0.43). USACE San Joaquin O&M Manual, Unit No. 601, Part No. 1, 1967, Amended in 1978, Revised 20 June 1985, (HLM 0.43). DWR As-Built Specification No. 62-03, Sheet No. 10, 18 June 1962, (HLM 0.43)]. FS Date: 7/12/2021

LS toe: Headwall buried under vegetation.

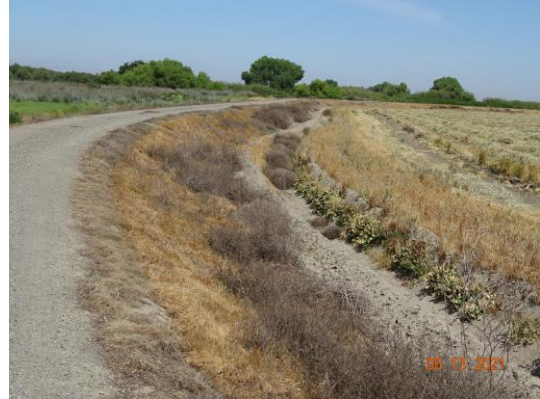
Photo 1 of 1 : FA_2024_NA0010_121_13_20240828_00006.jpg

LM Start	0.43	Rating **	A/W	Issue No.	13
LM End	2.02	Issue Type +	En	Location *	LS
Category	Earthen Levee			GPS Latitude/Longitude	
				Start	End
Item	Encroachments			37.106072 °	37.089499 °
				-120.585636 °	-120.568041 °
DWR ID	DWR_NA0010_03_s _ 2021_13				
Comment Code					
DT : Ditch					
Inspector Comment					
Ditch has been move approximately 10-15 off the levee toe.

View of ditch dug on the landside toe. (Spring 2021)

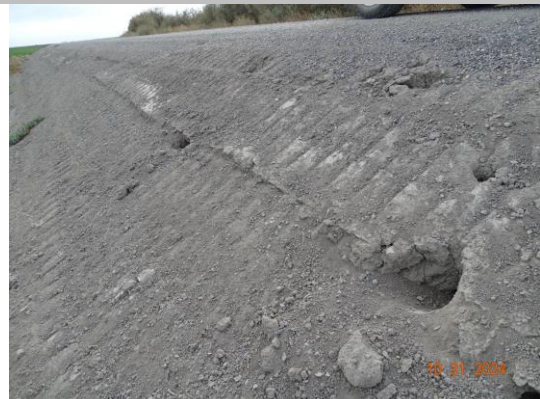
Photo 1 of 1 : FA_2024_NA0010_121_15_20241105_00019.jpg

LM Start	0.65	Rating **	M	Issue No.	15
LM End	0.67	Issue Type +	Ma	Location *	LS
Category	Earthen Levee			GPS Latitude/Longitude	
				Start	End
Item	Animal Control			37.103635 °	37.103540 °
				-120.583176 °	-120.582863 °
DWR ID	DWR_NA0010_03_s _ 2021_15				
Comment Code					
A1 : Exterminate rodents and backfill and compact or grout burrows.					
Inspector Comment					
Rodent burrows need to be backfilled and compacted.

View of rodent holes on the landside slope. (Fall 2024)

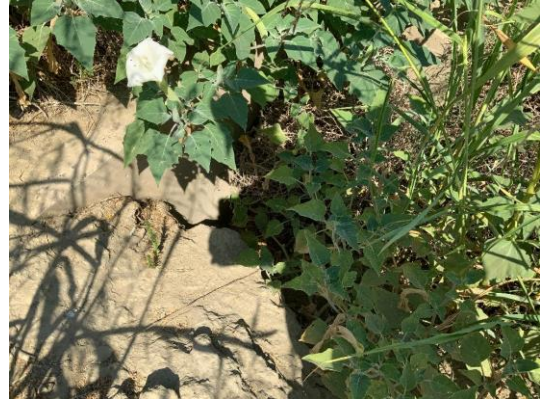
Photo 1 of 2 : UCIP_FA_2024_83306_101351.jpg

DS_ID:19692
FS_ID:83306
EP_NO: N/A
Repair Type: Non-Urgent
EVAL Issue:
Crossing Status: Found
UCIP Comments: 07/12/2021 The record has been upgraded from No Action Needed to Non-Urgent. Dense vegetation over LS pipe inlet, headwall barely visible. Minor vegetation on WS, recommend removal on both ends. No permit was found authorizing this encroachment. CVFPB will need to review crossing to determine owner. The UCIP inspection was completed with GEI staff, P. Espinoza. (H. Dunn ? GEI)
FIELD_STRUCT_DESC: 24-inch corrugated metal gravity drainage pipe (CMP) through the levee, 9.3 feet below the crown. Flap gate on the waterside (WS) end. [Additional Reference(s): DWR Levee Log, 2002, (HLM 0.78). USACE San Joaquin O&M Manual, Unit No. 601, Part No. 1, 1967, Amended in 1978, Revised 20 June 1985, (HLM 0.77). DWR As-Built Specification No. 62-03, Sheet No. 10, 18 June 1962, (HLM 0.77)].
FS Date: 7/12/2021

LS view: Pipe inlet and headwall covered in vegetation.

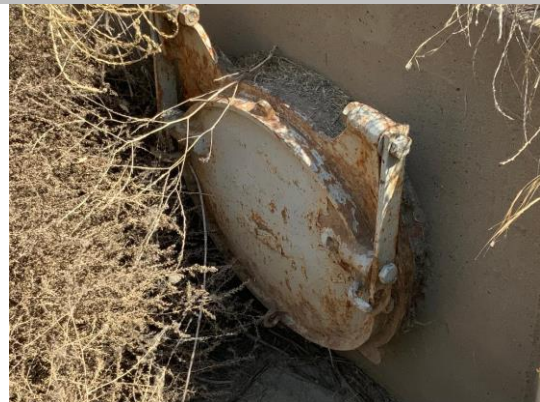
Photo 2 of 2 : UCIP_FA_2024_83306_101353.jpg

WS view: Closeup of flapgate at toe.

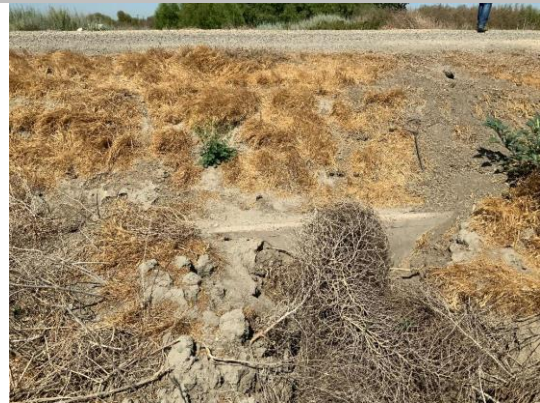
Photo 1 of 2 : UCIP_FA_2024_83307_101359.jpg

Comment Code						
Inspector Comment						
DS_ID:19693 FS_ID:83307 EP_NO: N/A Repair Type: Non-Urgent EVAL Issue: 5, Pipe Damage Crossing Status: Found UCIP Comments: 09/25/2024 DMP internal video inspection has found moderate pipe defects. Crossing will be monitored until funding becomes available for rehabilitation. (O. Yakimov - DWR UCIP) 07/12/2021 The record remains Non-Urgent. There is dense vegetation over LS pipe inlet and WS flap gate, recommend removal. No permit was found authorizing this encroachment. CVFPB will need to review crossing to determine owner. The UCIP inspection was completed with GEI staff, P. Espinoza. (H. Dunn ? GEI)04/17/2014 Sediment buildup in pipe visible from landward side--recommend clearing. (O. Magana - DWR UCIP) FIELD_STRUCT_DESC: 24-inch corrugated metal gravity drainage pipe (CMP) through the levee, 6.8 feet below the crown. Flap gate on the waterside (WS) end. [Additional Reference(s): DWR Levee Log, 2002, (HLM 1.73). USACE San Joaquin O&M Manual, Unit No. 601, Part No. 1, 1967, Amended in 1978, Revised 20 June 1985, (HLM 1.72). DWR As-Built Specification No. 62-03, Sheet No. 11, 18 June 1962, (HLM 1.72)]. FS Date: 7/12/2021

LS view: Slope and headwall from toe.

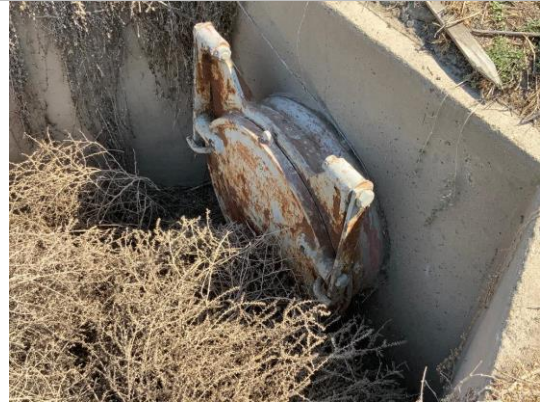
Photo 2 of 2 : UCIP_FA_2024_83307_101356.jpg

WS view: Close up of flapgate at toe.

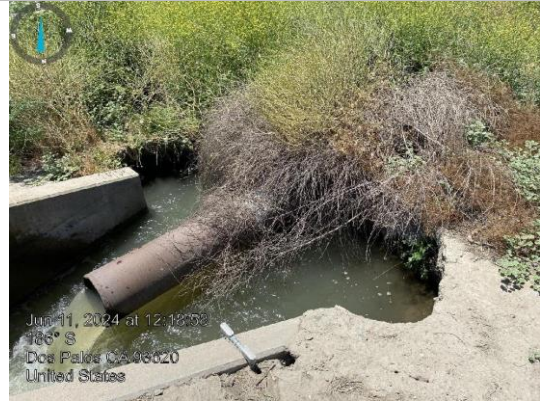
Photo 2 of 3 : UCIP_FA_2024_84570_124936.jpg

Comment Code					
Inspector Comment					
DS_ID:19694 FS_ID:84570 EP_NO: N/A Repair Type: Urgent EVAL Issue: 2b, Levee Integrity Crossing Status: Found UCIP Comments: 08/07/2024 Notice to comply Case No. 2024-15687 issued to this crossing due to significant erosion of the levee around both landside and waterside headwalls, unauthorized modifications to install a flow meter and an electric conduit through the 36-inch CMP discharge pipe, unpermitted and non-compliant 16-inch steel pipe near the waterside headwall. (O. Yakimov - DWR UCIP) 07/12/2021 The record remains Non-Urgent. Dense vegetation over WS and LS inlet/outlet, recommend removal. As mentioned in the previous inspection, there is a 16 inch metal pipe directly opposite the WS pipe slidegate/outlet that goes just underground and out through to the channel. Recommend contacting owner for more information on these WS appurtenances. No permit was found authorizing this encroachment. CVFPB will need to review crossing to determine owner. The UCIP inspection was completed with GEI staff, P. Espinoza. (H. Dunn ? GEI)04/17/2014 Need to contact owner--additional appurtenances found on waterward side not part of original description. Unable to determine if walkway, pump, and pipe through waterward berm is if part of original crossing. (O. Magana - DWR UCIP) FIELD_STRUCT_DESC: 36-inch corrugated metal irrigation discharge pipe (CMP) through the levee, 6.6 feet below the crown. Pump on the riverbank. Slide gate on the waterside (WS) end. (Permanent retention of removable low lift pump authorized under Permit No. 3399, 1961 - Virgill H. Menefee D.D.S). [Additional Reference(s): DWR Levee Log, 2002, (HLM 2.05). USACE San Joaquin O&M Manual, Unit No. 601, Part No. 1, 1967, Amended in 1978, Revised 20 June 1985, (HLM 2.05). DWR As-Built Specification No. 62-03, Sheet No. 11, 18 June 1962, (HLM 2.05)]. FS Date: 7/12/2021

Water-Side: View of erosion around waterside 36-inch CMP pipe opening and 16-inch steel pipe. Photo courtesy by CVFPB

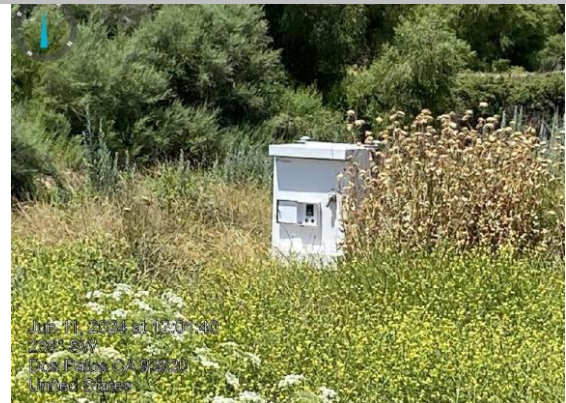
Photo 3 of 3 : UCIP_FA_2024_84570_124935.jpg

Water-Side: View showing electrical control box. Photo courtesy by CVFPB

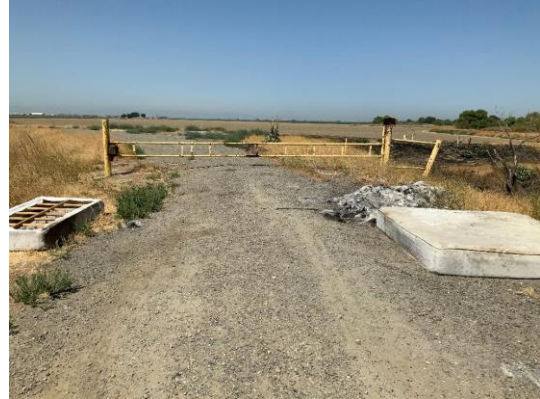
Photo 1 of 3 : UCIP_FA_2024_72284_101380.jpg

Comment Code						
Inspector Comment						
DS_ID:19977 FS_ID:72284 EP_NO: 5024 Repair Type: Non-Urgent EVAL Issue: Crossing Status: Found UCIP Comments: 07/12/2021 The record remains Non-Urgent. WS pipe outlet is underwater, limited inspection. LS headwall and pipe inlets have human trash around and safety concerns to inspectors due to homeless encampments. Limited inspection on both WS due to water and LS due to safety concerns to the inspectors. The UCIP inspection was completed with GEI staff, P. Espinoza. (H. Dunn ? GEI) 10/27/2017 This structure is inspected annually under the Structure and Channel Summer Inspection (part of the Levee Inspection Program) conducted by the DWR Flood Project Integrity and Inspection Branch (FPIIB). (O. Magana - DWR UCIP) 04/17/2014 Slide gates blocked by sediment. Recommend contacting owner to determine status of crossing. Crossing appears to be abandoned. (O. Magana - DWR UCIP) FIELD_STRUCT_DESC: [San Joaquin River Diversion Structure] 1 of 4: 72-inch by 60-inch reinforced concrete box gravity drainage culvert (RCBC) through the levee, 21.0 feet below the crown. Slide gate on the waterside (WS). Concrete headwalls on both WS and landside (LS) end. LS slope cobble revetted. (Existing RCBC modified to include slide gates authorized under Permit No. 5024, 1966 - Lower San Joaquin Levee District). [Additional Reference(s): DWR Levee Log, 2002, (HLM 0.03). DWR As-Built Specification No. 59-01, Sheets 23, 27, 28, and 72, 4 June 1962. DWR As-Built Specification No. 62-03, Sheet 10, 18 June 1962]. FS Date: 7/12/2021

Levee crown.

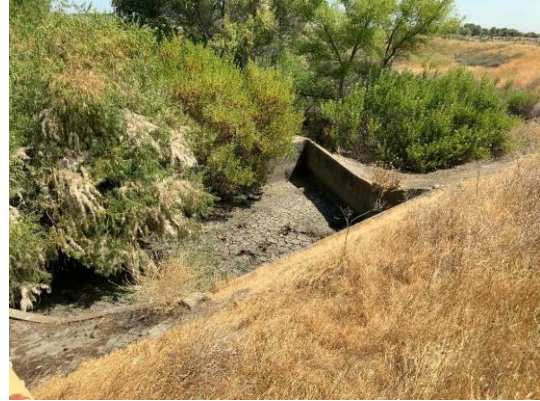
Photo 2 of 3 : UCIP_FA_2024_72284_101378.jpg

LS view: Toe from crown.

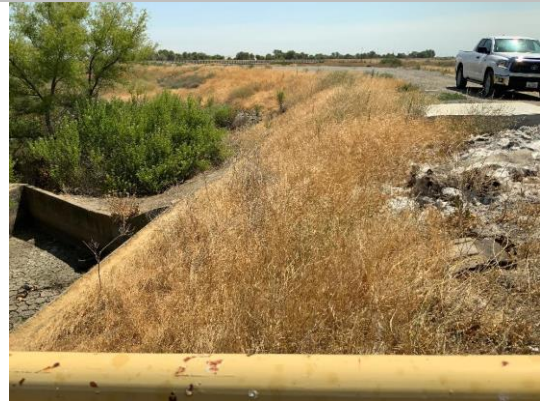
Photo 3 of 3 : UCIP_FA_2024_72284_101379.jpg

LS view: Slope from crown.

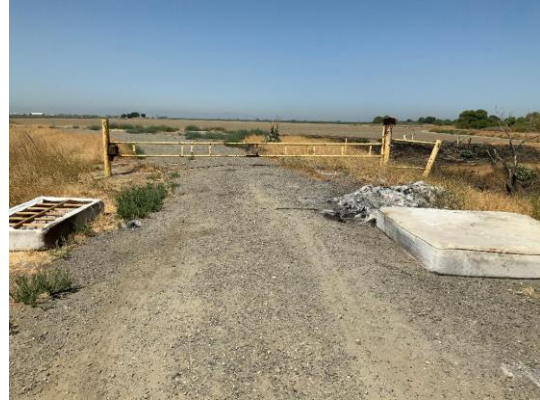
Photo 1 of 3 : UCIP_FA_2024_72285_101386.jpg

Comment Code						
Inspector Comment						
DS_ID:24856 FS_ID:72285 EP_NO: 5024 Repair Type: Non-Urgent EVAL Issue: Crossing Status: Found UCIP Comments: 07/12/2021 The record remains Non-Urgent. WS pipe outlet is underwater, limited inspection. LS headwall and pipe inlets have human trash around and safety concerns to inspectors due to homeless encampments. Limited inspection on both WS due to water and LS due to safety concerns to the inspectors. The UCIP inspection was completed with GEI staff, P. Espinoza. (H. Dunn ? GEI) 10/27/2017 This structure is inspected annually under the Structure and Channel Summer Inspection (part of the Levee Inspection Program) conducted by the DWR Flood Project Integrity and Inspection Branch (FPIIB). (O. Magana - DWR UCIP) 04/17/2014 Slide gates blocked by sediment. Recommend contacting owner to determine status of crossing. Crossing appears to be abandoned. (O. Magana - DWR UCIP) FIELD_STRUCT_DESC: [San Joaquin River Diversion Structure] 2 of 4: 72-inch by 60-inch reinforced concrete box gravity drainage culvert (RCBC) through the levee, 21.0 feet below the crown. Slide gate on the waterside (WS). Concrete headwalls on both WS and landside (LS) end. LS slope cobble revetted. (Existing RCBC modified to include slide gates authorized under Permit No. 5024, 1966 - Lower San Joaquin Levee District). [Additional Reference(s): DWR Levee Log, 2002, (HLM 0.03). DWR As-Built Specification No. 59-01, Sheets 23, 27, 28, and 72, 4 June 1962. DWR As-Built Specification No. 62-03, Sheet 10, 18 June 1962]. FS Date: 7/12/2021

Levee crown.

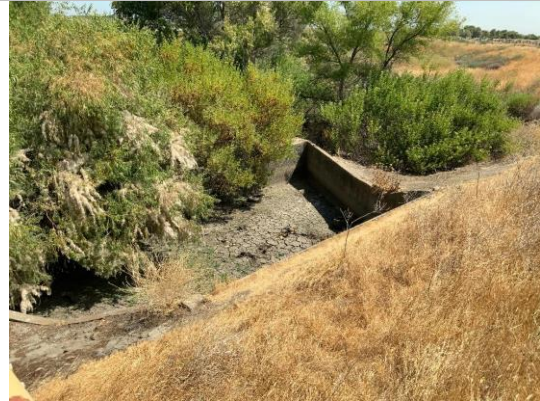
Photo 2 of 3 : UCIP_FA_2024_72287_101395.jpg

Comment Code						
Inspector Comment						
DS_ID:24858 FS_ID:72287 EP_NO: 5024 Repair Type: Non-Urgent EVAL Issue: Crossing Status: Found UCIP Comments: 07/12/2021 The record remains Non-Urgent. WS pipe outlet is underwater, limited inspection. LS headwall and pipe inlets have human trash around and safety concerns to inspectors due to homeless encampments. Limited inspection on both WS due to water and LS due to safety concerns to the inspectors. The UCIP inspection was completed with GEI staff, P. Espinoza. (H. Dunn ? GEI)0/27/2017 This structure is inspected annually under the Structure and Channel Summer Inspection (part of the Levee Inspection Program) conducted by the DWR Flood Project Integrity and Inspection Branch (FPIIB). (O. Magana - DWR UCIP) 04/17/2014 Slide gates blocked by sediment. Recommend contacting owner to determine status of crossing. Crossing appears to be abandoned. (O. Magana - DWR UCIP) FIELD_STRUCT_DESC: [San Joaquin River Diversion Structure] 4 of 4: 72-inch by 60-inch reinforced concrete box gravity drainage culvert (RCBC) through the levee, 21.0 feet below the crown. Slide gate on the waterside (WS). Concrete headwalls on both WS and landside (LS) end. LS slope cobble revetted. (Existing RCBC modified to include slide gates authorized under Permit No. 5024, 1966 - Lower San Joaquin Levee District). [Additional Reference(s): DWR Levee Log, 2002, (HLM 0.03). DWR As-Built Specification No. 59-01, Sheets 23, 27, 28, and 72, 4 June 1962. DWR As-Built Specification No. 62-03, Sheet 10, 18 June 1962]. FS Date: 7/12/2021

LS view: Headwall visible at toe from crown.

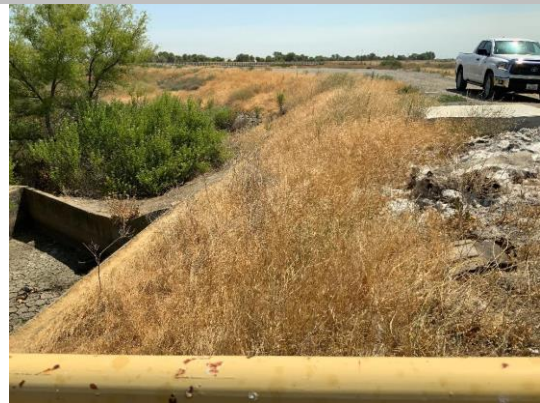
Photo 3 of 3 : UCIP_FA_2024_72287_101396.jpg

LS view: Slope from crown.

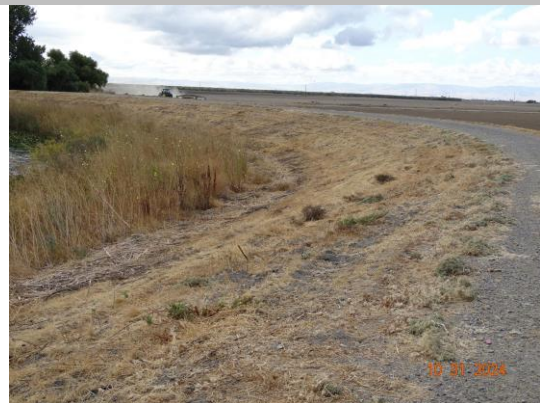
Photo 1 of 1 : FA_2024_NA0010_122_2_20241105_00004.jpg

LM Start	0.13	Rating **	A	Issue No.	2
LM End	0.13	Issue Type +	Ma	Location *	WS
Category	Earthen Levee			GPS Latitude/Longitude	
				Start	End
Item	Vegetation			37.111381 °	37.111381 °
				-120.590817 °	-120.590817 °
DWR ID	DWR_NA0010_04_f_2024_2				
Comment Code					
V1 : Control annual grass and weeds on the levee slopes and easements.					
Inspector Comment

View of the vegetation management on the waterside slope. (Fall 2024)

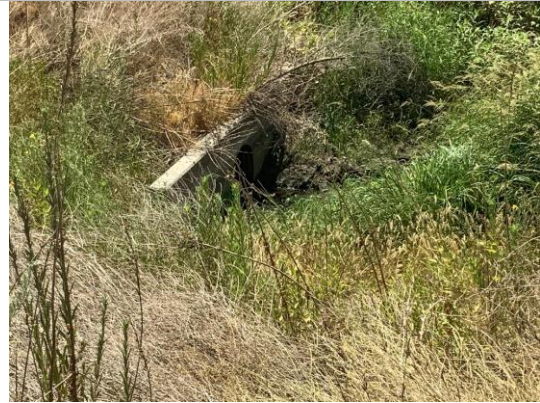
Photo 1 of 2 : UCIP_FA_2024_70974_101406.jpg

Comment Code						
Inspector Comment						
DS_ID:19695 FS_ID:70974 EP_NO: N/A Repair Type: Non-Urgent EVAL Issue: 11, Maintenance Compliance Issue Crossing Status: Found UCIP Comments: 07/12/2021 The record remains Non-Urgent. WS flapgate is underwater and covered by vegetation. LS inlet also covered by vegetation, recommend removal on both ends. No permit was found authorizing this encroachment. CVFPB will need to review crossing to determine owner. The UCIP inspection was completed with GEI staff, P. Espinoza. (H. Dunn ? GEI)04/17/2014 Sediment and debris blocking concrete headwall located on waterward side. During inspection water was flowing from landward side to waterward side. Recommend removing sediment to confirm condition of flap gate and pipe. (O. Magana - DWR UCIP) FIELD_STRUCT_DESC: 36-inch corrugated metal gravity drainage pipe (CMP) through the levee, 18.0 feet below the crown. Flap gate on the waterside (WS) end. Concrete headwall on each end. [Additional Reference(s): DWR Levee Log, 2002, (HLM 0.24). USACE San Joaquin O&M Manual, Unit No. 601, Part No. 1, 1967, Amended in 1978, Revised 20 June 1985, (HLM 0.27)]. FS Date: 7/12/2021

LS view: Pipe inlet with water in it at toe.

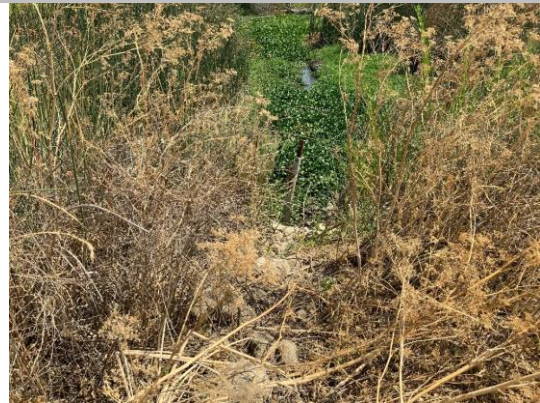
Photo 2 of 2 : UCIP_FA_2024_70974_101408.jpg

WS view: Pipe and flapgate not visible due to dense vegetation and water.

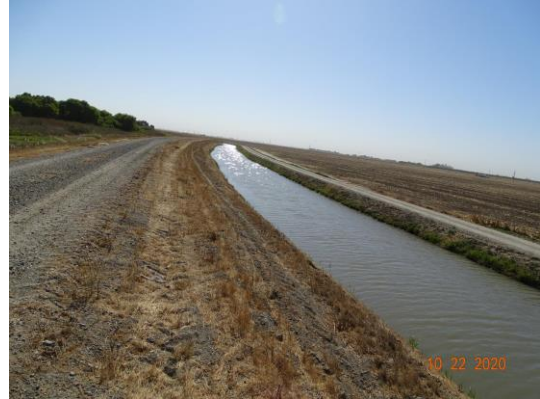
Photo 1 of 1 : FA_2024_NA0010_122_3_20240828_00001.jpg

LM Start	0.32	Rating **	A/W	Issue No.	3
LM End	1.41	Issue Type +	En	Location *	LS
Category	Earthen Levee			GPS Latitude/Longitude	
				Start	End
Item	Encroachments			37.108822 °	37.097556 °
				-120.590718 °	-120.578130 °
DWR ID	DWR_NA0010_04_s_2012_3				
Comment Code					
DT : Ditch					
Inspector Comment					
An irrigation ditch is within 10' easement. Shown on the as-built drawings.

Looking upstream at an irrigation ditch at the landside toe. (Fall 2020)

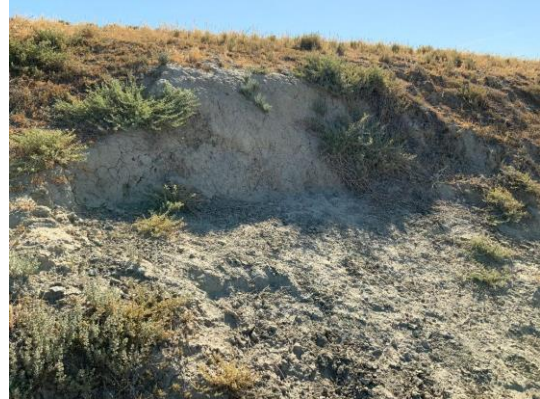
Photo 1 of 2 : UCIP_FA_2024_70983_99632.jpg

Comment Code					
Inspector Comment					
DS_ID:19756 FS_ID:70983 EP_NO: N/A Repair Type: Non-Urgent EVAL Issue: 6, Levee Damage or Threat for Levee Damage Crossing Status: Found UCIP Comments: 06/1/2021 Record remains Non-Urgent. DWR DMP internal inspection has not found pipe integrity issues. LOF of crossing is less or equal to 4.0. Recommend next video inspection in 5 years. Some soil sloughing/erosion on the WS slope. No permit was found authorizing this encroachment. CVFPB will need to review crossing to determine owner. The UCIP inspection was completed with GEI staff, P. Espinoza. (H. Dunn ? GEI)04/09/2014 Debris blocking landward headwall--recommend clearing. (W. Wylie - DWR UCIP) FIELD_STRUCT_DESC: 24-inch corrugated metal gravity drainage pipe (CMP) through the levee, 8.6 feet below the crown. Concrete U-shaped headwall and flap gate on the waterside (WS) end. Concrete headwall on the landside (LS) end. [Additional Reference(s): DWR Levee Log, 2002, (HLM 0.07). USACE San Joaquin O&M Manual, Unit No. 601, Part No. 1, 1967, Amended in 1978, Revised 20 June 1985, (HLM 0.07)]. FS Date: 6/1/2021

WS view: Sloughing on the slope from toe, 1 of 2 photos.

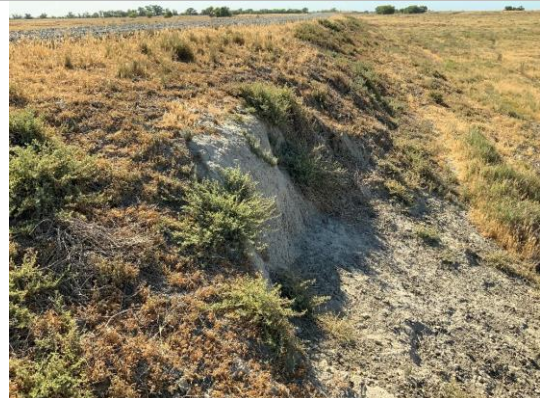
Photo 2 of 2 : UCIP_FA_2024_70983_99633.jpg

WS view: Side view of the sloughing on the slope, 2 of 2 photos.

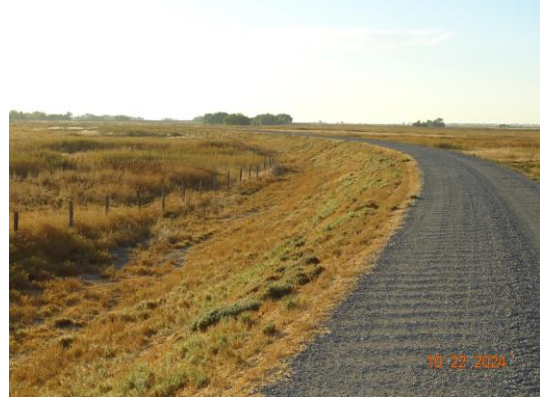
Photo 1 of 1 : FA_2024_NA0010_123_96_20241105_00284.jpg

LM Start	0.09	Rating **	A	Issue No.	96
LM End	0.09	Issue Type +	Ma	Location *	LS
Category	Earthen Levee	GPS Latitude/Longitude			
		Start	End		
Item	Vegetation	37.278036°		37.278036°	
		-120.823312°		-120.823312°	
DWR ID	DWR_NA0010_05_f_2024_96				
Comment Code					
V1 : Control annual grass and weeds on the levee slopes and easements.					
Inspector Comment

View of vegetation management on the landside slope. (Fall 2024)

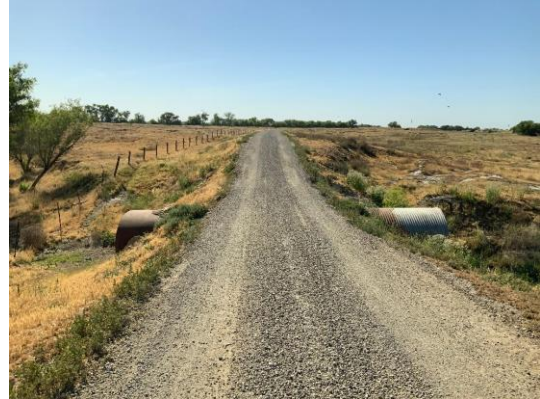
Photo 1 of 3 : UCIP_FA_2024_70984_99641.jpg

Comment Code					
Inspector Comment					
DS_ID:24867 FS_ID:70984 EP_NO: N/A Repair Type: Urgent EVAL Issue: 2b, Levee Integrity Crossing Status: Found UCIP Comments: 09/25/2024 DMP internal video inspection has found moderate pipe defects. Crossing will be monitored until funding becomes available for rehabilitation. (O. Yakimov - DWR UCIP) 06/1/2021 Record remains Urgent. Same as previous inspection comments. There is no flapgate, the pipe is open on both ends. Pipe is being bent down from the top. Crown has subsided about 4 feet from the original crown. Minor erosion around pipe on both WS and LS. No permit was found authorizing this encroachment. CVFPB will need to review crossing to determine owner. The UCIP inspection was completed with GEI staff, P. Espinoza. (H. Dunn ? GEI)11/01/2018 Same as previous inspection, 1960s levee breach; degraded levee section that drops about 4 feet within a 100-foot levee section. Crossing remains Urgent due to the levee degradation at this location. (O. Magana - DWR UCIP)7/20/2016 same as previous inspection. Levee section at crossing has been degraded. According to LMA representative, Rick, the low point at crossing has been present for over 10 years when the pipe was replaced. (O. Magana - DWR UCIP)4/09/2014 Pipe is open on both ends and levee has been degraded at this location. No permit identified for this crossing. (W. Wylie - DWR UCIP) FIELD_STRUCT_DESC: 96-inch corrugated metal gravity drainage pipe (CMP) through the levee, 4.5 feet below the crown. Pipe is composed of two materials: CMP on the waterside (WS) and steel pipe on the landside (LS). This section of the levee is a degraded section that drops approximately 4 feet within 100 feet of length. This section of the levee is the site of the 1960s levee breach. [Additional Reference(s): USACE Periodic Inspection Report 2014, USACE_CESPK_L05A_2014_p_0014]. FS Date: 6/1/2021

Levee crown looking downstream. Crown is lower above pipe.

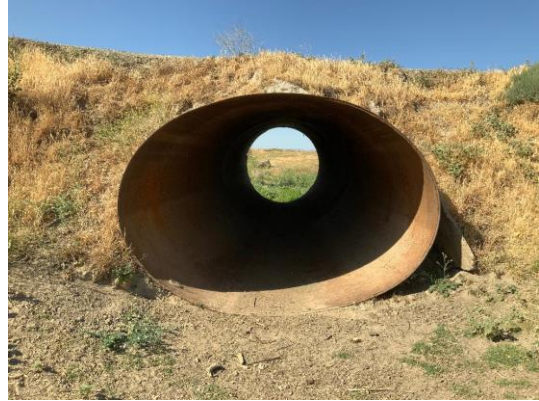
Photo 2 of 3 : UCIP_FA_2024_70984_99642.jpg

LS view: Slope and pipe inlet, top being bent down from toe.

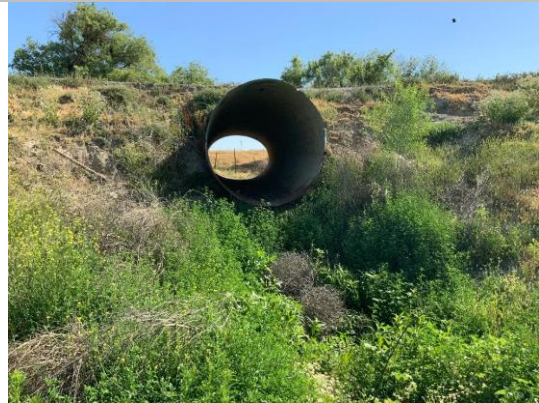
Photo 3 of 3 : UCIP_FA_2024_70984_99639.jpg

WS view: Slope and pipe outlet at toe.

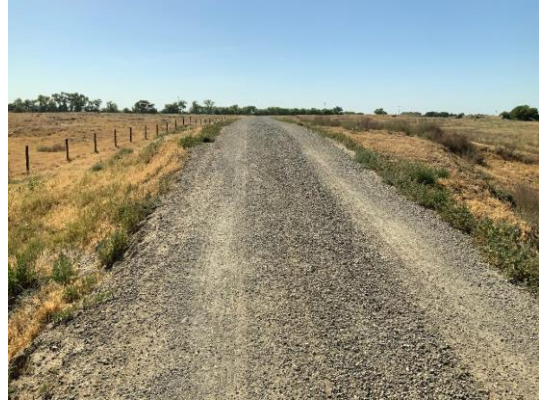
Photo 1 of 3 : UCIP_FA_2024_70985_99649.jpg

Comment Code						
Inspector Comment						
DS_ID:19557 FS_ID:70985 EP_NO: N/A Repair Type: Non-Urgent EVAL Issue: Crossing Status: Not Found UCIP Comments: 06/1/2021 Record remains Non-Urgent. Pipe not found by visual inspection. No permit was found authorizing this encroachment. CVFPB will need to review crossing to determine owner. The UCIP inspection was completed with GEI staff, P. Espinoza. (H. Dunn ? GEI) 10/1/2018 24-inch corrugated metal pipe (CMP) section found during pipe inspection of dsid 24867 (see photos); according to LMA representative levee section is the location of levee breach from 1960s; 24-inch pipe was undersized and was replaced after levee breach with a 96-inch CMP and steel pipe. (O. Magana - DWR UCIP) FIELD_STRUCT_DESC: 24-inch corrugated metal gravity drainage pipe (CMP) through the levee, 5.6 feet below the crown. Flap gate on the waterside (WS) end. Large pipe found at this location. [Additional Reference(s): USACE San Joaquin O&M Manual, Unit No. 601, Part No. 1, 1967, Amended in 1978, Revised 20 June 1985, (HLM 0.30)]. FS Date: 6/1/2021

Levee crown looking downstream.

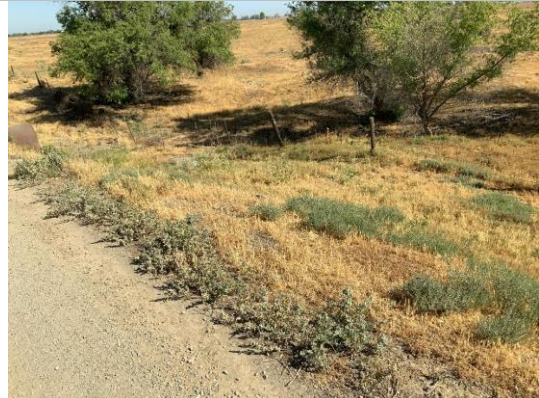
Photo 2 of 3 : UCIP_FA_2024_70985_99648.jpg

LS view: Slope and toe from crown, no pipe visible.

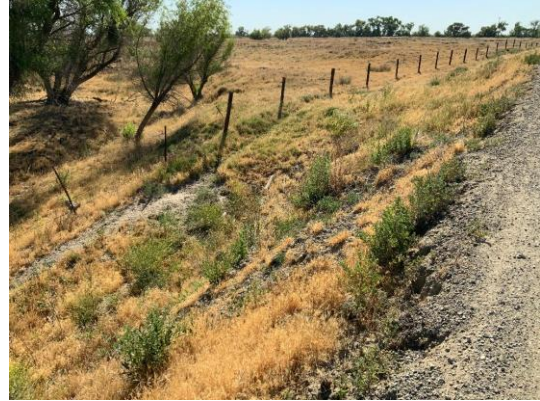
Photo 3 of 3 : UCIP_FA_2024_70985_99650.jpg

LS view: Toe from crown, no pipe visible.

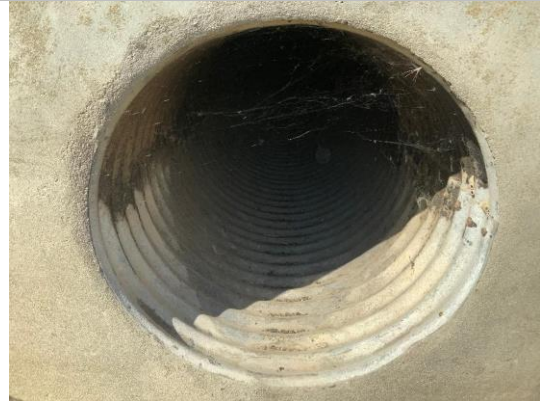
Photo 1 of 2 : UCIP_FA_2024_70986_99656.jpg

DS_ID:19757
FS_ID:70986
EP_NO: N/A
Repair Type: No Action Needed
EVAL Issue:
Crossing Status: Found
UCIP Comments: 09/18/2023 Record updated from Non-Urgent to No Action Needed. Pipe was CIPP lined. DMP internal video inspection has found none or minor pipe defects. Recommend next video inspection in 5 years. (O. Yakimov - DWR UCIP)
06/1/2021 Record remains Non-Urgent. DWR DMP internal inspection has found pipe integrity issues. LOF of crossing is greater than or equal to 4.1 and less than 5. Crossing will be monitored until funding becomes available for rehabilitation. No permit was found authorizing this encroachment. CVFPB will need to review crossing to determine owner. The UCIP inspection was completed with GEI staff, P. Espinoza. (H. Dunn ? GEI) 04/09/2014 Excess debris on landward headwall-- recommend clearing. (W. Wylie - DWR UCIP)
FIELD_STRUCT_DESC: 30-inch CIPP-lined corrugated metal gravity drainage pipe (CMP) through the levee, 7.5 feet below the crown. Flap gate on the waterside (WS) end. Concrete headwall on the landside (LS) end. Concrete U-shaped headwall on the WS end. [Additional Reference(s): DWR Levee Log, 2002, (HLM 0.58). USACE San Joaquin O&M Manual, Unit No. 601, Part No. 1, 1967, Amended in 1978, Revised 20 June 1985, (HLM 0.59). DWR As-Built Specification No. 63-25, Sheet No. 4, 9 May 1963, (Station -2+15)].

LS view: Close up of pipe inlet at toe.

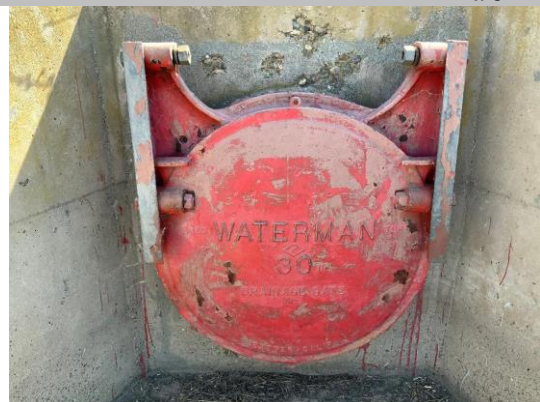
Photo 2 of 2 : UCIP_FA_2024_70986_99653.jpg

WS view: Close up of flapgate at toe.

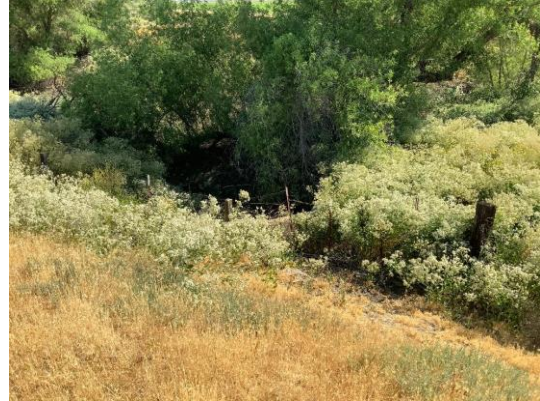
Photo 1 of 2 : UCIP_FA_2024_83309_99660.jpg

DS_ID:19758
FS_ID:83309
EP_NO: N/A
Repair Type: Non-Urgent
EVAL Issue:
Crossing Status: Found
UCIP Comments: 12/20/2022 Record updated from Urgent to Non-Urgent. Pipe has been CIPP-lined. LOF of crossing is less or equal to 4. Recommend next video inspection in 5 years. (O.Yakimov - DWR UCIP)
6/1/2021 Record has been upgraded from Non-Urgent to Urgent. DWR DMP internal inspection has found pipe integrity issues. LOF of crossing is greater than or equal to 5 and less than 6. Crossing will be monitored until funding becomes available to address the issues. No closeup inspection of LS pipe end due to dense vegetation and barbed wire. No permit was found authorizing this encroachment. CVFPB will need to review crossing to determine owner. The UCIP inspection was completed with GEI staff, P. Espinoza. (H. Dunn ? GEI)
09/09/2014 Dense vegetation limits the inspector's visibility to identify signs of pipe failure (leaks) along the landward slope. Recommend removing vegetation along pipe alignment to conduct proper inspection of structure. (W. Wylie - DWR UCIP)

LS view: Headwall barely visible at toe from crown.

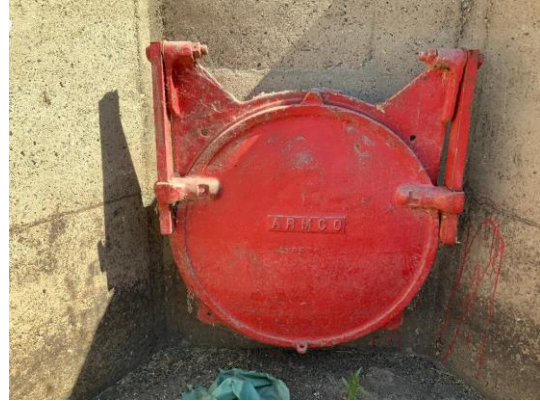
Photo 2 of 2 : UCIP_FA_2024_83309_99658.jpg

WS view: Close up of flapgate at toe.

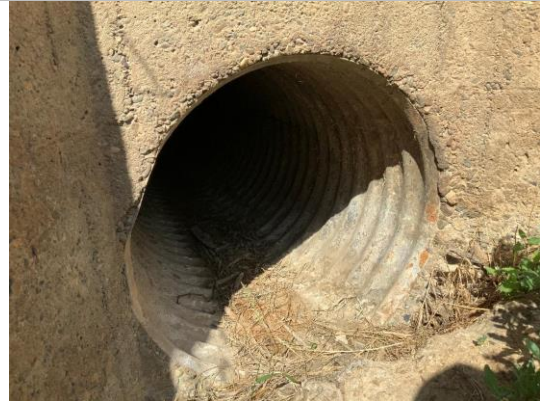
Photo 1 of 2 : UCIP_FA_2024_83314_99663.jpg

Comment Code						
Inspector Comment						
DS_ID:19759 FS_ID:83314 EP_NO: N/A Repair Type: No Action Needed EVAL Issue: Crossing Status: Found UCIP Comments: 04/25/2024 Record updated from Non-Urgent to No Action Needed. DMP internal video inspection has found none or minor pipe defects. (M. Thao - DWR UCIP) 12/20/2022 Record updated from Urgent to Non-Urgent. Pipe has been CIPP lined. LOF of crossing is less or equal to 4. Recommend next video inspection in 5 years. (O. Yakimov - DWR UCIP) 06/01/2021 Record has been upgraded from No Action Needed to Urgent. DWR DMP internal inspection has found pipe integrity issues. LOF of crossing is greater than or equal to 5 and less than 6. Crossing will be monitored until funding becomes available to address the issues. No permit was found authorizing this encroachment. CVFPB will need to review crossing to determine owner. The UCIP inspection was completed with GEI staff, P. Espinoza. (H. Dunn - GEI) FIELD_STRUCT_DESC: 24-inch CIPP-lined corrugated metal gravity drainage pipe (CMP) through the levee, 14.4 feet below the crown. Flap gate on the waterside (WS) end. Concrete headwall on the landside (LS) end. Concrete U-shaped headwall on the WS end. [Additional Reference(s): DWR Levee Log, 2002, (HLM 0.84). USACE San Joaquin O&M Manual, Unit No. 601, Part No. 1, 1967, Amended in 1978, Revised 20 June 1985, (HLM 0.84). DWR As-Built Specification No. 63-25, Sheet No. 4, 9 May 1963, (HLM 0.84)]. FS Date: 6/1/2021 11:24:27 AM

LS view: Close up of pipe inlet at toe.

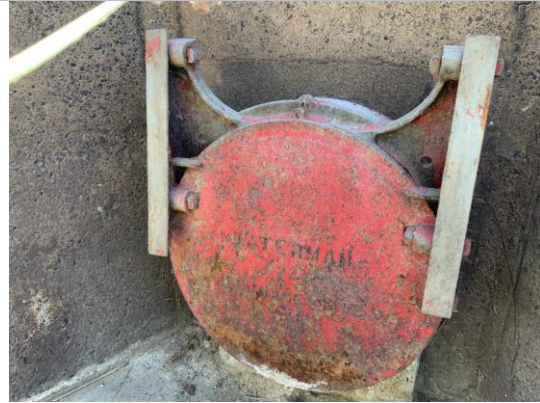
Photo 2 of 2 : UCIP_FA_2024_83314_99667.jpg

WS view: Close up of flapgate at toe.

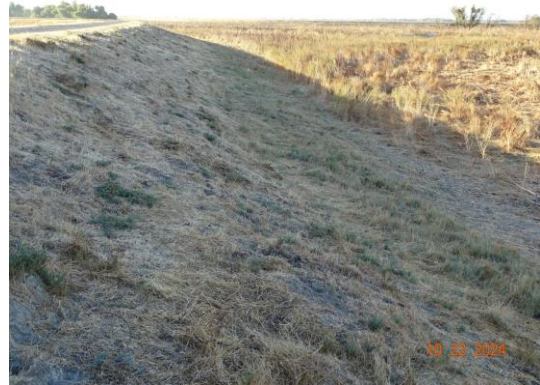
Photo 1 of 1 : FA_2024_NA0010_123_154_20241105_00285.jpg

LM Start	0.90	Rating **	A/W	Issue No.	154
LM End	0.90	Issue Type +	Ma	Location *	WS
Category	Earthen Levee			GPS Latitude/Longitude	
				Start	End
Item	Erosion / Livestock			37.271264 °	37.271264 °
				-120.811934 °	-120.811934 °
DWR ID	DWR_NA0010_05_s_2022_154				
Comment Code					
E4 : Repair the levee slope damaged by livestock and prevent large animal access.					
Inspector Comment					
Shallow depression on the lower 1/3 of the waterside slope. Possibly from livestock, but no visible trail leading to the depression. Continue to monitor.

View of minor slope erosion on the waterside. (Fall 2024)

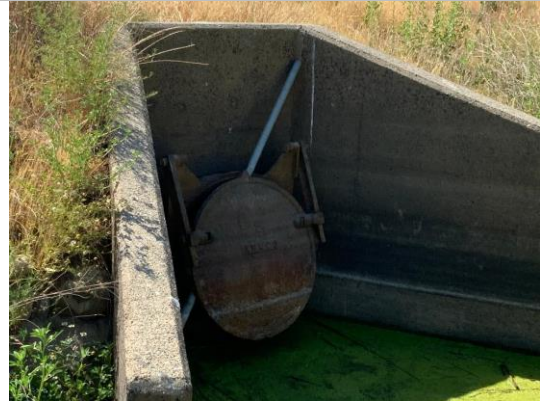
Photo 1 of 2 : UCIP_FA_2024_70989_99675.jpg

Comment Code						
Inspector Comment						
DS_ID:19760 FS_ID:70989 EP_NO: N/A Repair Type: Non-Urgent EVAL Issue: 11, Maintenance Compliance Issue Crossing Status: Found UCIP Comments: 06/1/2021 The record has been upgraded from No Action Needed to Non-Urgent. LS pipe inlet blocked by barbed wire, could not inspect. Small pipe lodged in the WS flapgate so it cannot be closed all the way, recommend removal before flood season. No permit was found authorizing this encroachment. CVFPB will need to review crossing to determine owner. The UCIP inspection was completed with GEI staff, P. Espinoza. (H. Dunn ? GEI) FIELD_STRUCT_DESC: 36-inch corrugated metal gravity drainage pipe (CMP) through the levee, 21.0 feet below the crown. Flap gate on the waterside (WS) end. Concrete headwall on the landside (LS) end. Concrete U-shaped headwall on the WS end. [Additional Reference(s): DWR Levee Log, 2002, (HLM 1.44). USACE San Joaquin O&M Manual, Unit No. 601, Part No. 1, 1967, Amended in 1978, Revised 20 June 1985, (HLM 1.44). DWR As-Built Specification No. 63-25, Sheet No. 4, 9 May 1963, (HLM 1.44)]. FS Date: 6/1/2021

WS view: Close up of flapgate at toe, 1 of 2 photos.

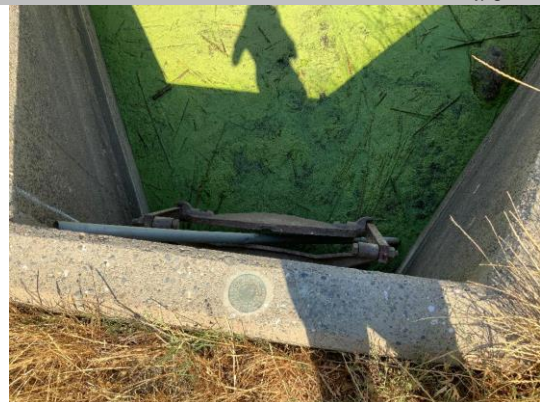
Photo 2 of 2 : UCIP_FA_2024_70989_99676.jpg

WS view: Close up of flapgate at toe with bar sticking through, 2 of 2 photos.

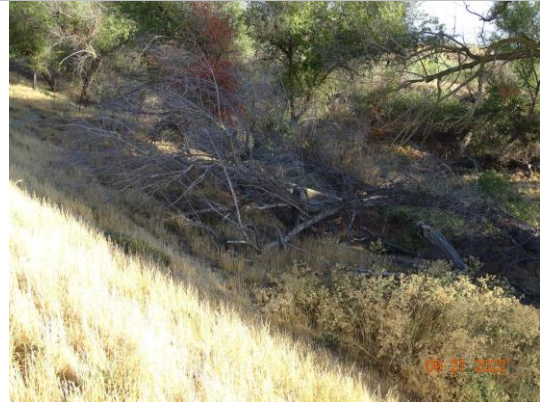
Photo 1 of 1 : FA_2024_NA0010_123_159_20240828_00039.jpg

LM Start	1.47	Rating **	M	Issue No.	159
LM End	1.47	Issue Type +	Ma	Location *	LS
Category	Earthen Levee			GPS Latitude/Longitude	
				Start	End
Item	Trim / Thin Trees			37.265605 °	37.265605 °
				-120.804784 °	-120.804784 °
DWR ID	DWR_NA0010_05_f_2022_159				
Comment Code					
T2 : Tree or limb.					
Inspector Comment					
Downed tree branch on the landside toe.

Fallen tree on the landside slope and toe. (Fall 2022)

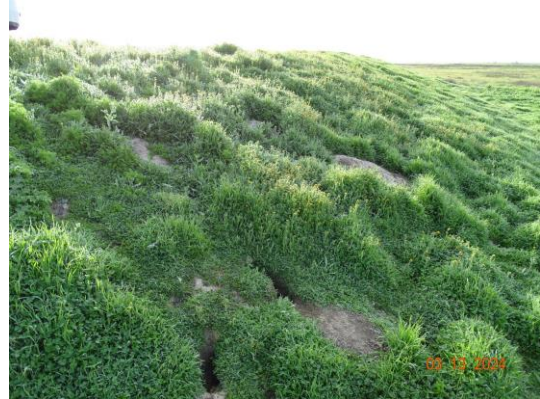
Photo 1 of 1 : FA_2024_NA0010_123_99_20240828_00007.jpg

LM Start	1.74	Rating **	A/W	Issue No.	99
LM End	1.74	Issue Type +	Ma	Location *	WS
Category	Earthen Levee			GPS Latitude/Longitude	
				Start	End
Item	Animal Control			37.262388 °	37.262388 °
				-120.802482 °	-120.802482 °
DWR ID	DWR_NA0010_05_s _ 2024_99				
Comment Code					
A3 : No rodents visible, but rodent burrows visible; need to backfill and compact or grout burrows.					
Inspector Comment					
Several rodent holes observed and appear to penetrate to the landside slope.

Several rodent holes noted at this section. (Spring 2024)

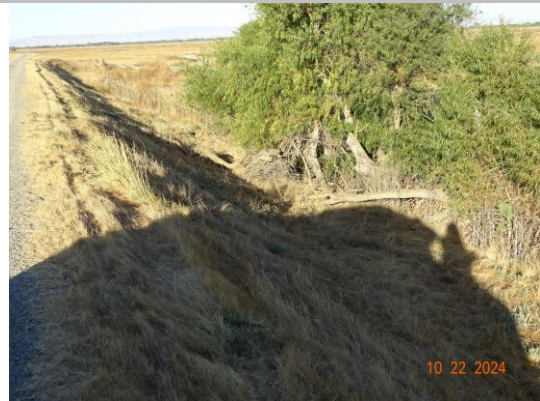
Photo 1 of 1 : FA_2024_NA0010_123_102_20241105_00286.jpg

LM Start	2.82	Rating **	M	Issue No.	102
LM End	2.82	Issue Type +	Ma	Location *	LS
Category	Earthen Levee			GPS Latitude/Longitude	
				Start	End
Item	Trim / Thin Trees			37.256805 °	37.256805 °
				-120.785434 °	-120.785434 °
DWR ID	DWR_NA0010_05_s _ 2019_102				
Comment Code					
T2 : Tree or limb.					
Inspector Comment					
Remove fallen tree limbs off of the landside toe.

Tree limb has fallen on the landside toe. (Fall 2024)

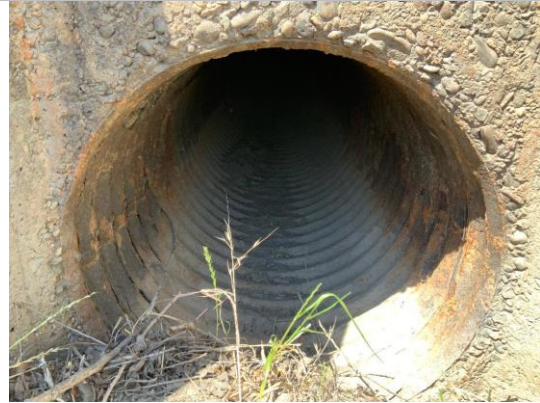
Photo 1 of 3 : UCIP_FA_2024_70991_99684.jpg

Comment Code						
Inspector Comment						
DS_ID:19810 FS_ID:70991 EP_NO: N/A Repair Type: No Action Needed EVAL Issue: Crossing Status: Found UCIP Comments: 09/18/2023 Record updated from Non-Urgent to No Action Needed. Pipe was CIPP lined. DMP internal video inspection has found none or minor pipe defects. Recommend next video inspection in 5 years. (O. Yakimov - DWR UCIP) 06/1/2021 Record remains Non-Urgent. DWR DMP internal inspection has found pipe integrity issues. LOF of crossing is between 4.1 and 5. Crossing will be monitored until funding becomes available for rehabilitation. Pipe is eroded through causing holes just behind the WS flapgate. Metal peeling away inside of pipe outlet. Flapgate is rusted with some corrosion. No permit was found authorizing this encroachment. CVFPB will need to review crossing to determine owner. The UCIP inspection was completed with GEI staff, P. Espinoza. (H. Dunn ? GEI) 04/15/2014 Pipe corroded through at flapgate on WS toe. (W. Wylie - DWR UCIP) FIELD_STRUCT_DESC: 24-inch CIPP-lined corrugated metal gravity drainage pipe (CMP) through the levee, 14.7 feet below the crown. Flap gate on the waterside (WS) end. Concrete U-shaped headwall on each end. [Additional Reference(s): DWR Levee Log, 2002, (HLM 3.36). USACE San Joaquin O&M Manual, Unit No. 601, Part No. 1, 1967, Amended in 1978, Revised 20 June 1985, (HLM 3.33). DWR As-Built Specification No. 63-25, Sheet No. 5, 9 May 1963, (HLM 3.33)]. FS Date: 6/1/2021

LS view: Close up of pipe inlet at toe.

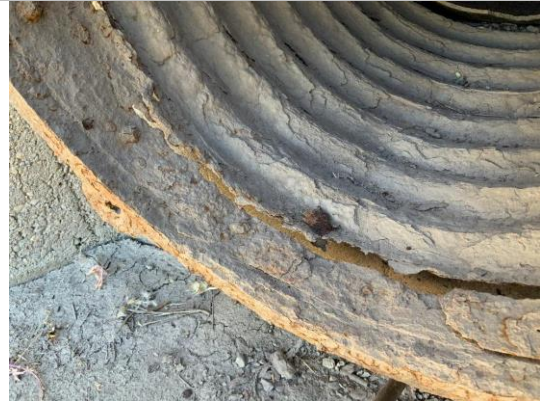
Photo 2 of 3 : UCIP_FA_2024_70991_99688.jpg

WS view: Corroded metal causing holes in pipe outlet at toe.

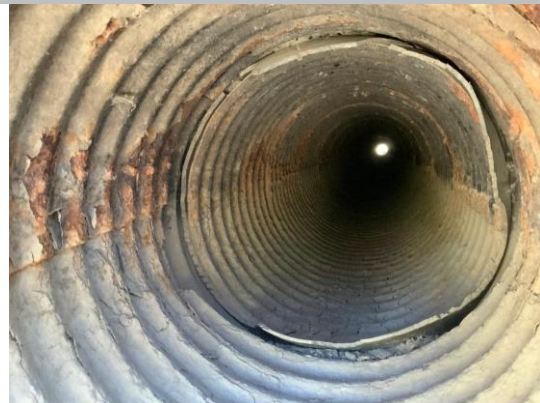
Photo 3 of 3 : UCIP_FA_2024_70991_99692.jpg

WS view: Inside pipe outlet at toe, peeling away of liner or metal, 1 of 2 photos.
