Flood Control Project Maintenance Levee Inspections

Fall 2024 Levee Maintenance Deficiency Summary Report

San Joaquin River Basin

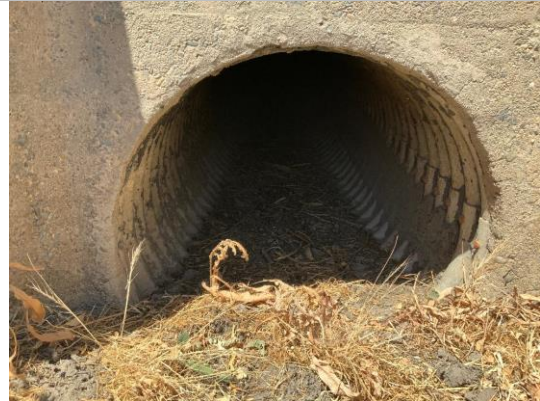
Photo 1 of 1 : UCIP_FA_2024_70992_99695.jpg

Comment Code						
Inspector Comment						
DS_ID:19811 FS_ID:70992 EP_NO: N/A Repair Type: Non-Urgent EVAL Issue: 11, Maintenance Compliance Issue Crossing Status: Found UCIP Comments: 06/1/2021 Record remains Non-Urgent. Some debris buildup within the LS pipe inlet, recommend cleaning out. No permit was found authorizing this encroachment. CVFPB will need to review crossing to determine owner. The UCIP inspection was completed with GEI staff, P. Espinoza. (H. Dunn ? GEI)04/16/2014 Sediment buildup in pipe visible from landward side--recommend contacting owner to clear pipe. (W. Wylie - DWR UCIP) FIELD_STRUCT_DESC: 24-inch corrugated metal gravity drainage pipe (CMP) through the levee, 15.0 feet below the crown. Flap gate on the waterside (WS) end. Concrete headwall on the landside (LS) end. Concrete U-shaped headwall on the WS end. [Additional Reference(s): DWR Levee Log, 2002, (HLM 3.67). USACE San Joaquin O&M Manual, Unit No. 601, Part No. 1, 1967, Amended in 1978, Revised 20 June 1985, (HLM 3.67). DWR As-Built Specification No. 63-25, Sheet No. 6, 9 May 1963, (HLM 3.67)]. FS Date: 6/1/2021

LS view: Close up of pipe inlet at toe, some debris buildup.

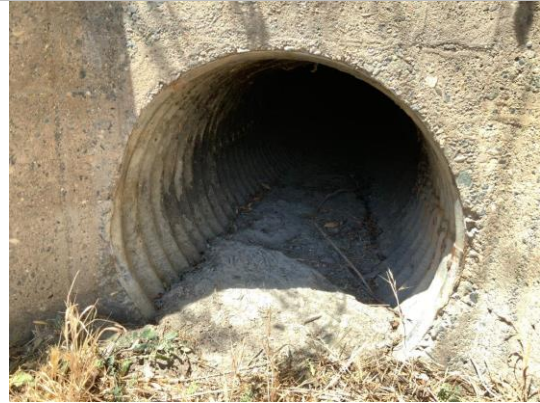
Photo 1 of 1 : UCIP_FA_2024_70993_99703.jpg

DS_ID:19769
FS_ID:70993
EP_NO: N/A
Repair Type: Non-Urgent
EVAL Issue: 5, Pipe Damage
Crossing Status: Found
UCIP Comments: 09/25/2024 DMP internal video inspection has found moderate pipe defects. Crossing will be monitored until funding becomes available for rehabilitation. (O. Yakimov - DWR UCIP)
06/1/2021 Record remains Non-Urgent. Some sediment buildup in LS pipe inlet, recommend cleaning out. No permit was found authorizing this encroachment. CVFPB will need to review crossing to determine owner. The UCIP inspection was completed with GEI staff, P. Espinoza. (H. Dunn ? GEI) 4/16/2014 Sediment buildup in pipe visible from landward side--recommend contacting owner to clear pipe. (W. Wylie - DWR UCIP)
FIELD_STRUCT_DESC: 24-inch corrugated metal gravity drainage pipe (CMP) through the levee, 16.0 feet below the crown. Flap gate on the waterside (WS) end. Concrete U-shaped headwall on each end.
[Additional Reference(s): DWR Levee Log, 2002, (HLM 4.01). USACE San Joaquin O&M Manual, Unit No. 601, Part No. 1, 1967, Amended in 1978, Revised 20 June 1985, (HLM 4.02). DWR As-Built Specification No. 63-25, Sheet No. 6, 9 May 1963, (HLM 4.02)].

LS view: Close up of pipe inlet with sediment buildup at toe.

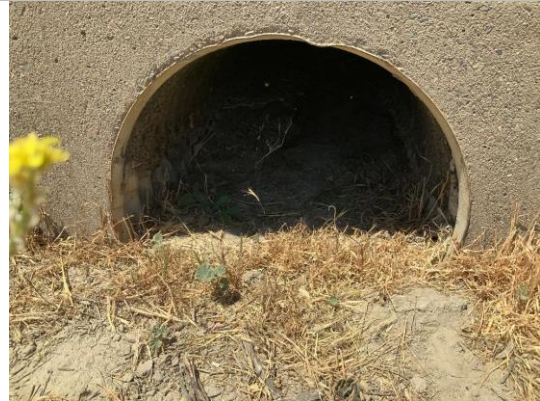
Photo 1 of 3 : UCIP_FA_2024_77866_99715.jpg

Comment Code						
Inspector Comment						
DS_ID:19770 FS_ID:77866 EP_NO: N/A Repair Type: Urgent EVAL Issue: 1, Pipe Integrity Crossing Status: Found UCIP Comments: 12/14/2022 Record updated from Non-Urgent to Urgent. DMP internal video inspection has found pipe integrity issues. LOF of crossing is between 5 and 6. Crossing will be monitored until funding becomes available to address the issues. (O.Yakimov - DWR UCIP) 06/1/2021 Record remains Non-Urgent. Sizable burrow complex on WS slope, with several holes around 3-4 inches wide, recommend filling in for levee integrity. There is also sediment buildup within the LS pipe inlet, recommend cleaning out. No permit was found authorizing this encroachment. CVFPB will need to review crossing to determine owner. The UCIP inspection was completed with GEI staff, P. Espinoza. (H. Dunn ? GEI)04/16/2014 Sediment buildup in pipe visible from landward side--recommend contacting owner to clear pipe. (W. Wylie - DWR UCIP) FIELD_STRUCT_DESC: 24-inch corrugated metal gravity drainage pipe (CMP) through the levee, 11.6 feet below the crown. Flap gate on the waterside (WS) end. Concrete headwall on the landside (LS) end. Concrete U-shaped headwall on the WS end. [Additional Reference(s): DWR Levee Log, 2002, (HLM 4.27). USACE San Joaquin O&M Manual, Unit No. 601, Part No. 1, 1967, Amended in 1978, Revised 20 June 1985, (HLM 4.27). DWR As-Built Specification No. 63-25, Sheet No. 6, 9 May 1963, (HLM 4.27)]. FS Date: 6/1/2021 1:53:07 PM

LS view: Close up of pipe inlet with sediment buildup at toe.

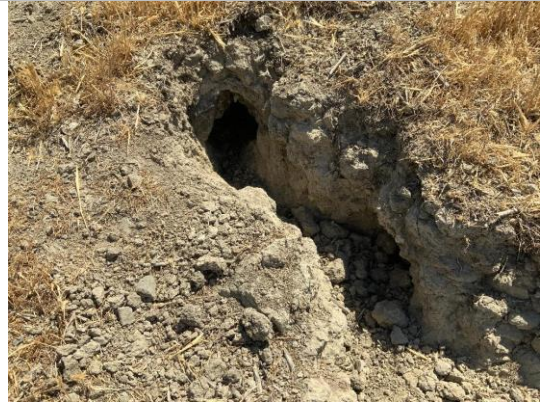
Photo 2 of 3 : UCIP_FA_2024_77866_99713.jpg

WS view: Burrow complex holes, 1 of 3 photos.

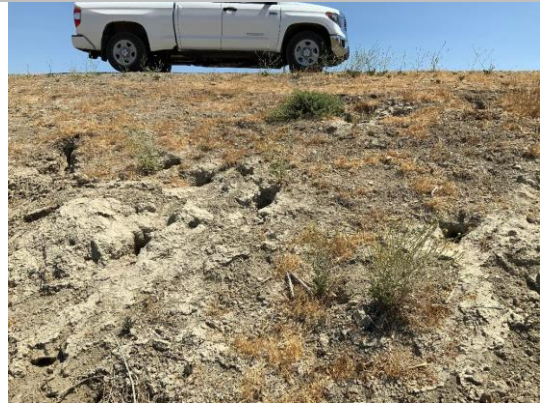
Photo 3 of 3 : UCIP_FA_2024_77866_99709.jpg

WS view: Burrow complex holes on slope from toe, 3 of 3 photos.

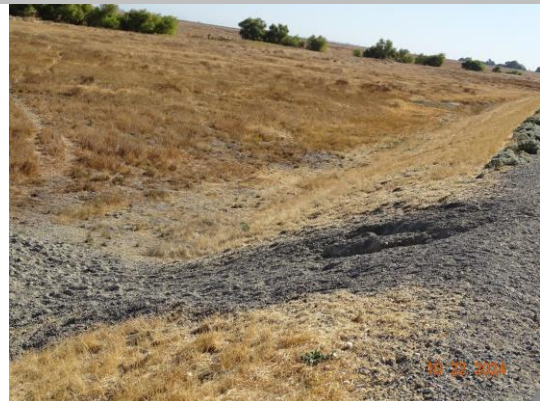
Photo 1 of 1 : FA_2024_NA0010_123_97_20241105_00287.jpg

LM Start	4.51	Rating **	M	Issue No.	97
LM End	4.51	Issue Type +	Ma	Location *	LS
Category	Earthen Levee			GPS Latitude/Longitude	
				Start	End
Item	Erosion / Livestock			37.243925 °	37.243925 °
				-120.757442 °	-120.757442 °
DWR ID	DWR_NA0010_05_f_2024_97				
Comment Code					
E4 : Repair the levee slope damaged by livestock and prevent large animal access.					
Inspector Comment

View of erosion on the landside slope and shoulder. (Fall 2024)

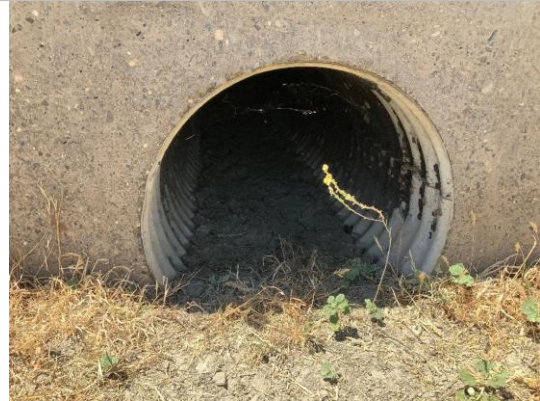
Photo 1 of 1 : UCIP_FA_2024_70995_99718.jpg

Comment Code						
Inspector Comment						
DS_ID:19771 FS_ID:70995 EP_NO: N/A Repair Type: Non-Urgent EVAL Issue: 5, Pipe Damage Crossing Status: Found UCIP Comments: 09/25/2024 DMP internal video inspection has found moderate pipe defects. Crossing will be monitored until funding becomes available for rehabilitation. (O. Yakimov - DWR UCIP) 06/1/2021 Record remains Non-Urgent. LS pipe inlet has sediment buildup inside, recommend cleaning out. No permit was found authorizing this encroachment. CVFPB will need to review crossing to determine owner. The UCIP inspection was completed with GEI staff, P. Espinoza. (H. Dunn ? GEI)04/16/2014 Sediment buildup in pipe visible from landward side--recommend contacting owner to clear pipe. (W. Wylie - DWR UCIP) FIELD_STRUCT_DESC: 24-inch corrugated metal gravity drainage pipe (CMP) through the levee, 12.0 feet below the crown. Flap gate on the waterside (WS) end. Concrete headwall on the landside (LS) end. Concrete U-shaped headwall on the WS end. [Additional Reference(s): DWR Levee Log, 2002, (HLM 4.53). USACE San Joaquin O&M Manual, Unit No. 601, Part No. 1, 1967, Amended in 1978, Revised 20 June 1985, (HLM 4.54). DWR As-Built Specification No. 63-25, Sheet No. 6, 9 May 1963, (HLM 4.54)]. FS Date: 6/1/2021

LS view: Close up of pipe inlet with sediment buildup at toe.

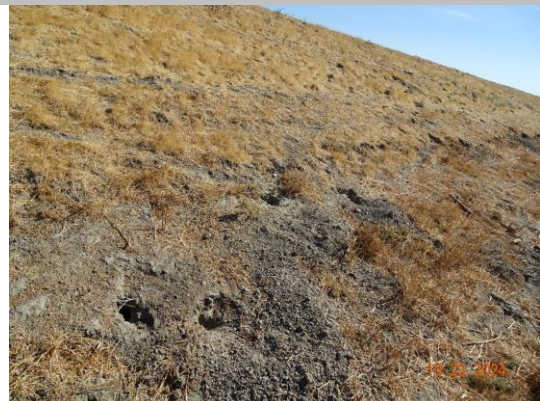
Photo 1 of 1 : FA_2024_NA0010_123_98_20241105_00288.jpg

LM Start	4.63	Rating **	M	Issue No.	98
LM End	4.63	Issue Type +	Ma	Location *	WS
Category	Earthen Levee			GPS Latitude/Longitude	
				Start	End
Item	Animal Control			37.242950 °	37.242950 °
				-120.755541 °	-120.755541 °
DWR ID	DWR_NA0010_05_f_2024_98				
Comment Code					
A1 : Exterminate rodents and backfill and compact or grout burrows.					
Inspector Comment					
Several squirrel burrows noted on the waterside slope and toe.

View of rodent burrows on the waterside slope. (Fall 2024)

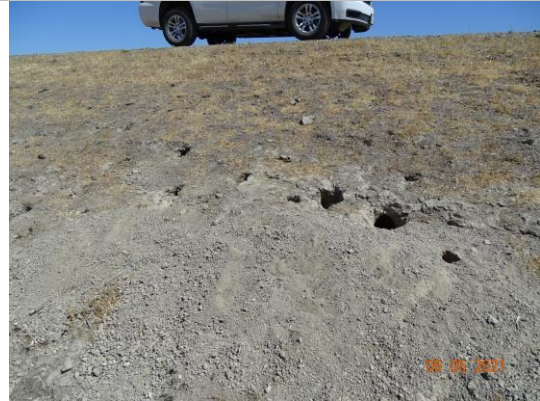
Photo 1 of 1 : FA_2024_NA0010_123_100_20240828_00008.jpg

LM Start	4.85	Rating **	M	Issue No.	100
LM End	4.85	Issue Type +	Ma	Location *	WS
Category	Earthen Levee			GPS Latitude/Longitude	
				Start	End
Item	Animal Control			37.241127 °	37.241127 °
				-120.752398 °	-120.752398 °
DWR ID	DWR_NA0010_05_s_2021_100				
Comment Code					
A1 : Exterminate rodents and backfill and compact or grout burrows.					
Inspector Comment					
Several burrows and rodents observed at this location. Bait stations have been set up.

Several rodent burrows noted at this location. (Spring 2021)

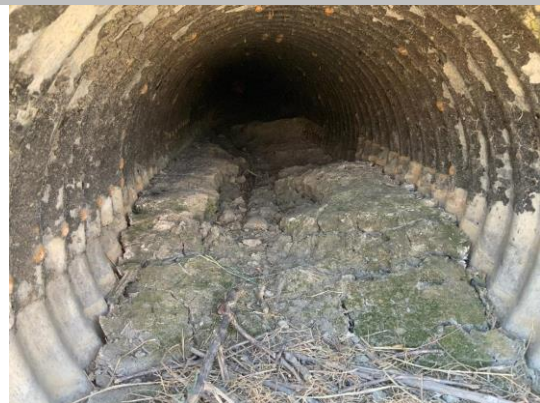
Photo 1 of 1 : UCIP_FA_2024_70996_100748.jpg

Comment Code						
Inspector Comment						
DS_ID:19772 FS_ID:70996 EP_NO: N/A Repair Type: Non-Urgent EVAL Issue: 5, Pipe Damage Crossing Status: Found UCIP Comments: 09/25/2024 DMP internal video inspection has found moderate pipe defects. Crossing will be monitored until funding becomes available for rehabilitation. (O. Yakimov - DWR UCIP) 06/1/2021 The record remains Non-Urgent. LS pipe inlet has sediment buildup, recommend cleaning out. No permit was found authorizing this encroachment. CVFPB will need to review crossing to determine owner. The UCIP inspection was completed with GEI staff, P. Espinoza. (H. Dunn ? GEI)04/16/2014 Heavy sediment buildup in pipe visible from landward side--recommend contacting owner to clear pipe. (W. Wylie - DWR UCIP) FIELD_STRUCT_DESC: 24-inch corrugated metal gravity drainage pipe (CMP) through the levee, 12.3 feet below the crown. Flap gate on the waterside (WS) end. Concrete headwall on the landside (LS) end. Concrete U-shaped headwall on the WS end. [Additional Reference(s): DWR Levee Log, 2002, (HLM 4.89). USACE San Joaquin O&M Manual, Unit No. 601, Part No. 1, 1967, Amended in 1978, Revised 20 June 1985, (HLM 4.89). DWR As-Built Specification No. 63-25, Sheet No. 7, 9 May 1963, (HLM 4.89)]. FS Date: 6/1/2021

LS view: Inside pipe inlet with sediment buildup at toe.

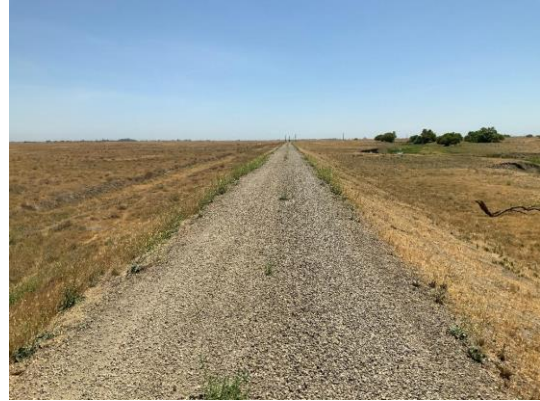
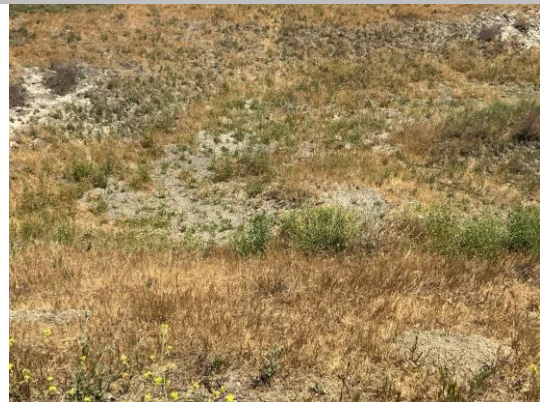
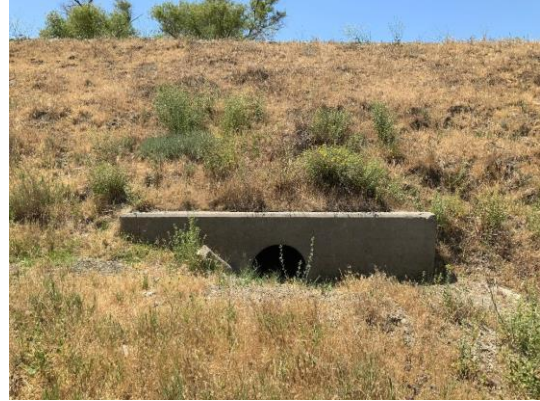
DS_ID:19773
FS_ID:77867
EP_NO: N/A
Repair Type: Urgent
EVAL Issue: 1, Pipe Integrity
Crossing Status: Found
UCIP Comments: 12/14/2022 Record updated from Non-Urgent to Urgent. DMP internal video inspection has found pipe integrity issues. LOF of crossing is between 5 and 6. Crossing will be monitored until funding becomes available to address the issues. (O.Yakimov - DWR UCIP)
06/1/2021 The record remains Non-Urgent. Crossing appears to be in good condition. No permit was found authorizing this encroachment. CVFPB will need to review crossing to determine owner. The UCIP inspection was completed with GEI staff, P. Espinoza. (H. Dunn ? GEI)
04/16/2014 Heavy sediment buildup in pipe visible from landward side--recommend contacting owner to clear pipe. (W. Wylie - DWR UCIP)
FIELD_STRUCT_DESC: 24-inch corrugated metal gravity drainage pipe (CMP) through the levee, 12.2 feet below the crown. Flap gate on the waterside (WS) end. Concrete headwall on the landside (LS) end. Concrete U-shaped headwall on the WS end. [Additional Reference(s): DWR Levee Log, 2002, (HLM 5.14). USACE San Joaquin O&M Manual, Unit No. 601, Part No. 1, 1967, Amended in 1978, Revised 20 June 1985, (HLM 5.15). DWR As-Built Specification No. 63-25, Sheet No. 7, 9 May 1963, (HLM 5.15)].

Levee crown looking upstream.

LS view: Toe from crown.

LS view: Slope and headwall at toe.

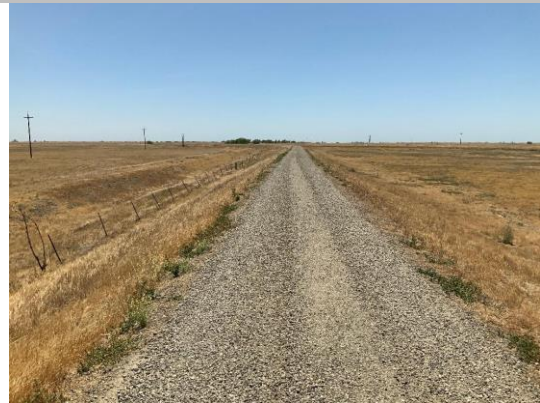
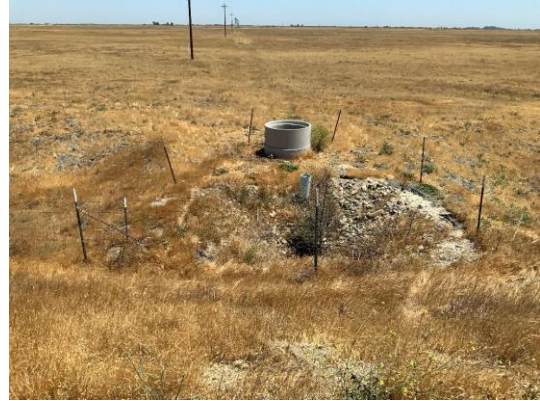
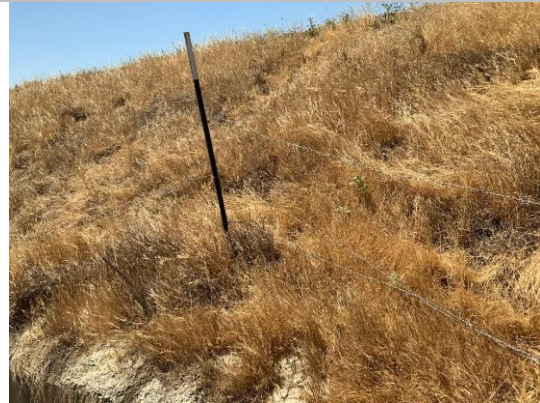
DS_ID:19774
FS_ID:77868
EP_NO: N/A
Repair Type: Urgent
EVAL Issue: 1, Pipe Integrity
Crossing Status: Found
UCIP Comments: 12/14/2022 Record updated from Non-Urgent to Urgent. DMP internal video inspection has found pipe integrity issues. LOF of crossing is between 5 and 6. Crossing will be monitored until funding becomes available to address the issues. (O.Yakimov - DWR UCIP)
06/1/2021 The record has been upgraded from No Action Needed to Non-Urgent. Crossing appears to be in good condition. No permit was found authorizing this encroachment. CVFPB will need to review crossing to determine owner. New concrete riser, plastic riser, and flowmeter off the LS toe going away from the levee. The UCIP inspection was completed with GEI staff, P. Espinoza. (H. Dunn ? GEI)
FIELD_STRUCT_DESC: 24-inch corrugated metal gravity drainage pipe (CMP) through the levee, 9.5 feet below the crown. Flap gate on the waterside (WS) end. Concrete headwall on the landside (LS) end. Concrete U-shaped headwall on the WS end. [Additional Reference(s): DWR Levee Log, 2002, (HLM 5.58). USACE San Joaquin O&M Manual, Unit No. 601, Part No. 1, 1967, Amended in 1978, Revised 20 June 1985, (HLM 5.58). DWR As-Built Specification No. 63-25, Sheet No. 7, 9 May 1963, (HLM 5.58)].

Levee crown looking upstream.

LS view: Toe from crown.

LS view: Slope from toe.

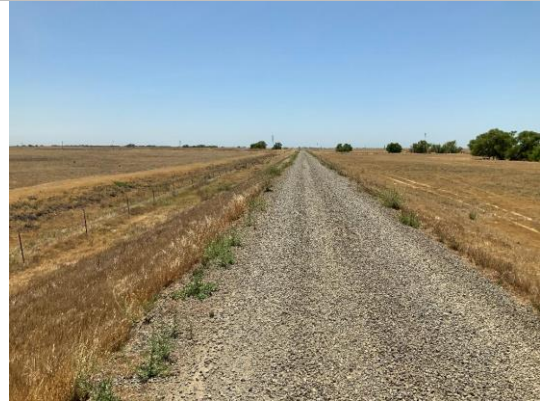
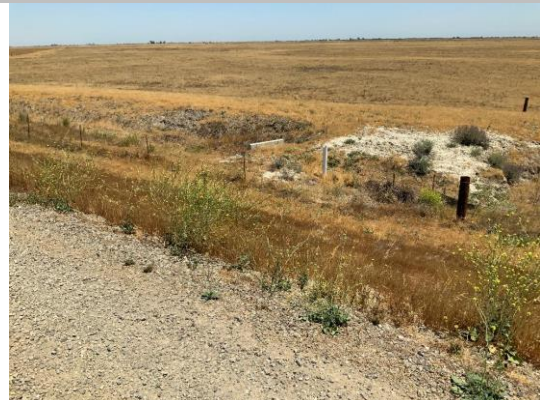
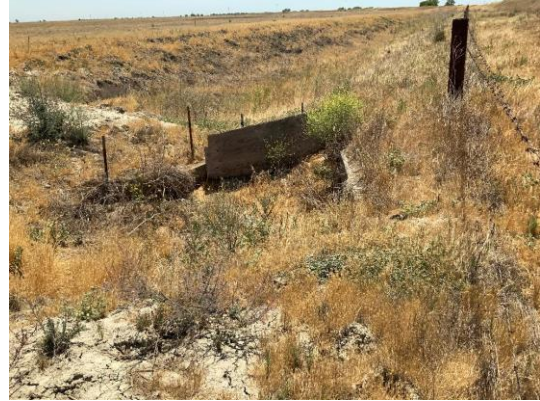
Comment Code					
Inspector Comment					
DS_ID:19775 FS_ID:70999 EP_NO: N/A Repair Type: Non-Urgent EVAL Issue: 5, Pipe Damage Crossing Status: Found UCIP Comments: 09/25/2024 DMP internal video inspection has found moderate pipe defects. Crossing will be monitored until funding becomes available for rehabilitation. (O. Yakimov - DWR UCIP) 06/1/2021 The record has been upgraded from No Action Needed to Non-Urgent. LS inlet blocked by barbed wire and was inaccessible, could not inspect. No permit was found authorizing this encroachment. CVFPB will need to review crossing to determine owner. The UCIP inspection was completed with GEI staff, P. Espinoza. (H. Dunn ? GEI) FIELD_STRUCT_DESC: 24-inch corrugated metal gravity drainage pipe (CMP) through the levee, 13.0 feet below the crown. Flap gate on the waterside (WS) end. Concrete headwall on the landside (LS) end. Concrete U-shaped headwall on the WS end. [Additional Reference(s): DWR Levee Log, 2002, (HLM 6.35). USACE San Joaquin O&M Manual, Unit No. 601, Part No. 1, 1967, Amended in 1978, Revised 20 June 1985, (HLM 6.35). DWR As-Built Specification No. 63-25, Sheet No. 8, 9 May 1963, (HLM 6.35)]. FS Date: 6/1/2021

Levee crown looking upstream.

LS view: Toe from crown.

LS view: Headwall visible at toe behind barbed wire.

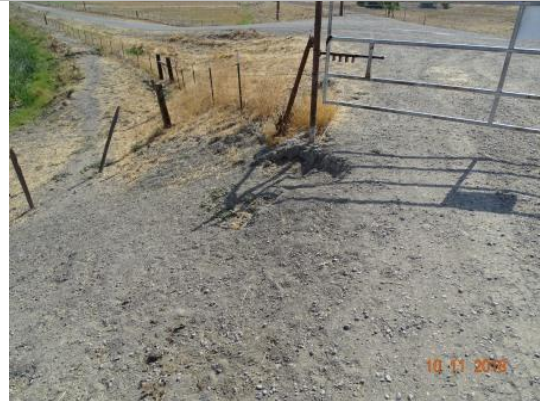
Photo 1 of 1 : FA_2024_NA0010_123_140_20240828_00030.jpg

LM Start	6.56	Rating **	A/W	Issue No.	140
LM End	6.56	Issue Type +	Ma	Location *	LS
Category	Earthen Levee			GPS Latitude/Longitude	
				Start	End
Item	Erosion / Livestock			37.230013 °	37.230013 °
				-120.726832 °	-120.726832 °
DWR ID	DWR_NA0010_05_f_2018_140				
Comment Code					
E4 : Repair the levee slope damaged by livestock and prevent large animal access.					
Inspector Comment					
Erosion on slope near the gate has been repaired with loose material. Monitor for settlement.

Erosion on landward slope caused by animal foot traffic. (Fall 2018)

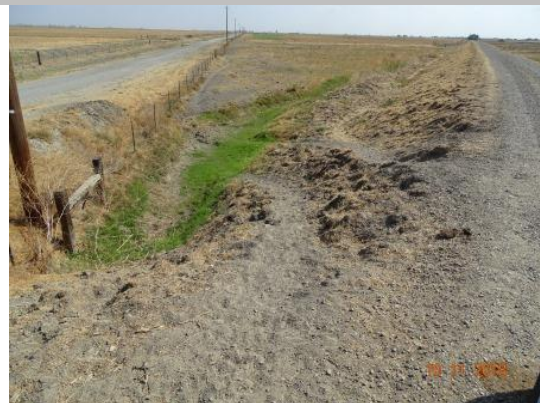
Photo 1 of 1 : FA_2024_NA0010_123_1309_20240828_00066.jpg

LM Start	6.59	Rating **	A/W	Issue No.	1309
LM End	6.59	Issue Type +	Ma	Location *	LS
Category	Earthen Levee			GPS Latitude/Longitude	
				Start	End
Item	Erosion / Livestock			37.229682 °	37.229682 °
				-120.726305 °	-120.726305 °
DWR ID	DWR_NA0010_05_s_2015_1309				
Comment Code					
E4 : Repair the levee slope damaged by livestock and prevent large animal access.					
Inspector Comment					
The landside slope has damage caused by animal foot traffic but the integrity of the levee is not compromised. Continue to monitor.

Looking upstream at damaged landside slope. (Fall 2018)

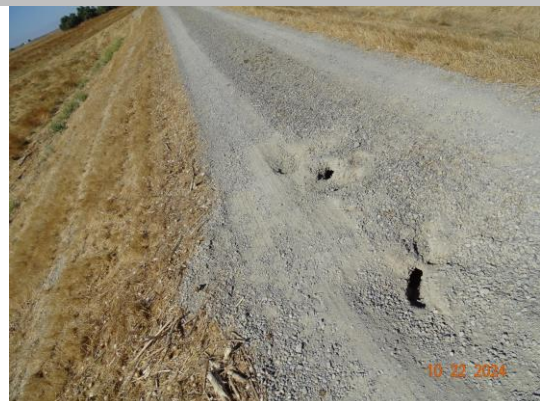
Photo 1 of 1 : FA_2024_NA0010_123_103_20241105_00289.jpg

LM Start	6.98	Rating **	M	Issue No.	103
LM End	6.98	Issue Type +	Ma	Location *	CR
Category	Earthen Levee			GPS Latitude/Longitude	
				Start	End
Item	Animal Control			37.227207 °	37.227207 °
				-120.720023 °	-120.720023 °
DWR ID	DWR_NA0010_05_f_2024_103				
Comment Code					
A3 : No rodents visible, but rodent burrows visible; need to backfill and compact or grout burrows.					
Inspector Comment

View of rodent holes within the levee crown. (Fall 2024)

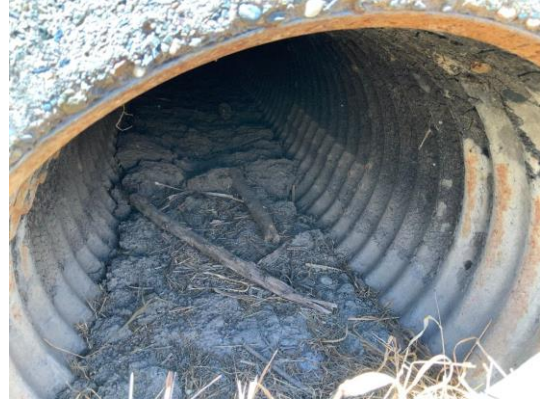
Photo 1 of 1 : UCIP_FA_2024_71000_100779.jpg

Comment Code						
Inspector Comment						
DS_ID:19761 FS_ID:71000 EP_NO: N/A Repair Type: Non-Urgent EVAL Issue: 5, Pipe Damage Crossing Status: Found UCIP Comments: 09/25/2024 DMP internal video inspection has found moderate pipe defects. Crossing will be monitored until funding becomes available for rehabilitation. (O. Yakimov - DWR UCIP) 06/9/2021 The record remains Non-Urgent. Sediment buildup in LS pipe inlet, recommend removal. No permit was found authorizing this encroachment. CVFPB will need to review crossing to determine owner. The UCIP inspection was completed with GEI staff, P. Espinoza. (H. Dunn ? GEI)04/22/2014 Sediment buildup in pipe visible from landward side--recommend contacting owner to clear pipe. (W. Wylie - DWR UCIP) FIELD_STRUCT_DESC: 24-inch corrugated metal gravity drainage pipe (CMP) through the levee, 12.0 feet below the crown. Flap gate on the waterside (WS) end. Concrete headwall on the landside (LS) end. Concrete U-shaped headwall on the WS end. [Additional Reference(s): DWR Levee Log, 2002, (HLM 7.36). USACE San Joaquin O&M Manual, Unit No. 601, Part No. 1, 1967, Amended in 1978, Revised 20 June 1985, (HLM 7.36). DWR As-Built Specification No. 63-25, Sheet No. 8, 9 May 1963, (HLM 7.36)]. FS Date: 6/9/2021

LS view: Closeup of pipe inlet with sediment buildup at toe.

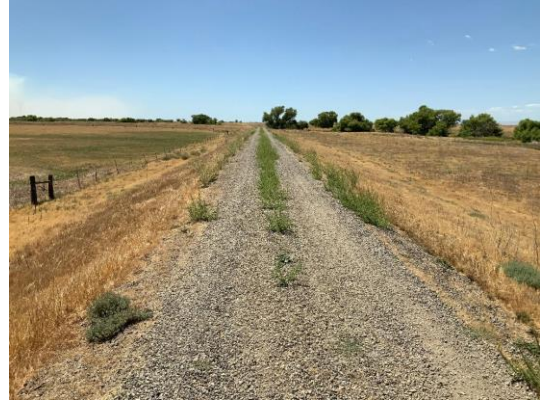
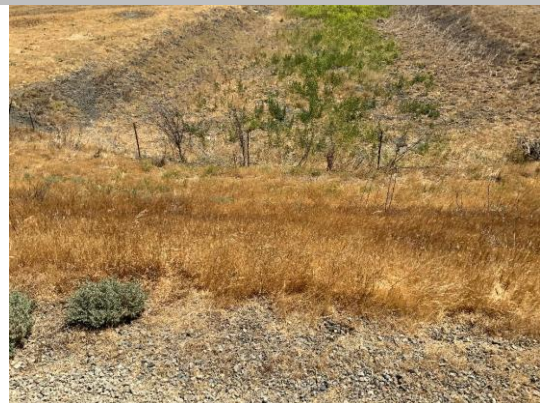
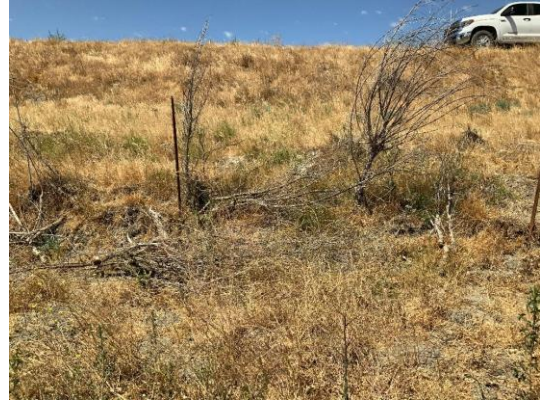
Comment Code						
Inspector Comment						
DS_ID:19762 FS_ID:71001 EP_NO: N/A Repair Type: Non-Urgent EVAL Issue: Crossing Status: Indicator Found UCIP Comments: 06/9/2021 The record remains Non-Urgent. No pipe visible on WS or LS during inspection, only indicator found. WS metal riser is bent. DWR DMP Geophysical study indicates possible presence of pipe through levee at (2305907, -13523234), coordinates have been updated. Owner needs to coordinate with the CVFPB to remove or abandon crossing according to Title 23 requirements. No permit was found authorizing this encroachment. CVFPB will need to review crossing to determine owner. The UCIP inspection was completed with GEI staff, P. Espinoza. (H. Dunn ? GEI)04/22/2014 Appears abandoned and if so should be done so properly. Slide gate rusted shut on WS slope. Unable to locate inlet or outlet. (W. Wylie - DWR UCIP) FIELD_STRUCT_DESC: 24-inch corrugated metal gravity drainage pipe (CMP) through the levee, 20.4 feet below the crown. Slide gate in a 36-inch CMP riser unit on the waterside (WS) slope. Concrete U-shaped headwall on each end. [Additional Reference(s): DWR Levee Log, 2002, (HLM 7.57). USACE San Joaquin O&M Manual, Unit No. 601, Part No. 1, 1967, Amended in 1978, Revised 20 June 1985, (HLM 7.58). DWR As-Built Specification No. 63-25, Sheet No. 9, 9 May 1963, (HLM 7.58)]. FS Date: 6/9/2021

Levee crown looking upstream.

LS view: Toe from crown.

LS view: Slope from toe, no pipe visible.

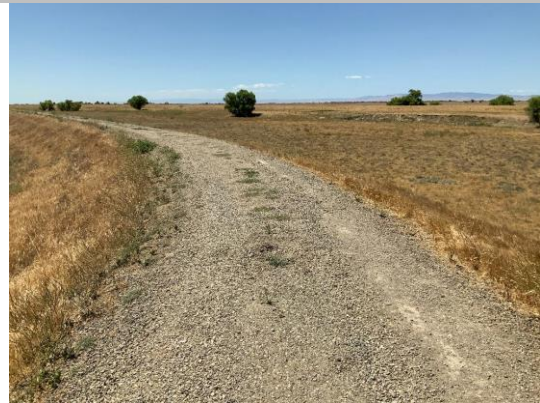
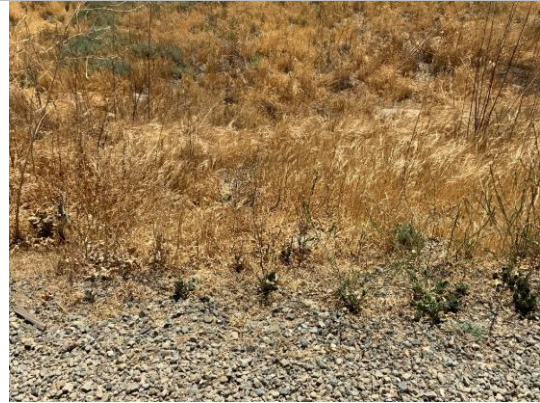
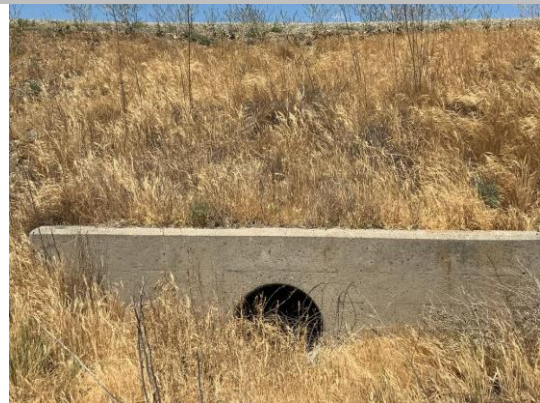
DS_ID:19844
 FS_ID:71002
 EP_NO: N/A
 Repair Type: Non-Urgent
 EVAL Issue:
 Crossing Status: Found
 UCIP Comments: 06/9/2021 The record has been upgraded from No Action Needed to Non-Urgent. DWR DMP internal inspection has not found pipe integrity issues. LOF of crossing is less or equal to 4.0. Recommend next video inspection in 5 years. No permit was found authorizing this encroachment. CVFPB will need to review crossing to determine owner. The UCIP inspection was completed with GEI staff, P. Espinoza. (H. Dunn ? GEI)08/01/2018 USACE O&M manual has pipe listed under Unit 10 HLM 0.02, however, based on the current levee alignment pipe is located under Unit 5 CLM 7.68. Discrepancy in pipe O&M reference is based on reference between Historic Levee Alignment and Current Levee Alignment. (DWR UCIP - O. Magana)
 FIELD_STRUCT_DESC: 24-inch corrugated metal gravity drainage pipe (CMP) through the levee, 9.4 feet below the crown. Flap gate on the waterside (WS) end. Concrete headwall on the landside (LS) end. Concrete U-shaped headwall on the WS end. [Additional Reference(s): DWR Levee Log, 2002. USACE San Joaquin O&M Manual, Unit No. 601, Part No. 1, 1967, Amended in 1978, Revised 20 June 1985, (recorded as Unit 10 HLM 0.02, located in Unit 5 CLM 7.68)].

Levee crown looking upstream.

LS view: Toe from crown.

LS view: Slope and headwall at toe.

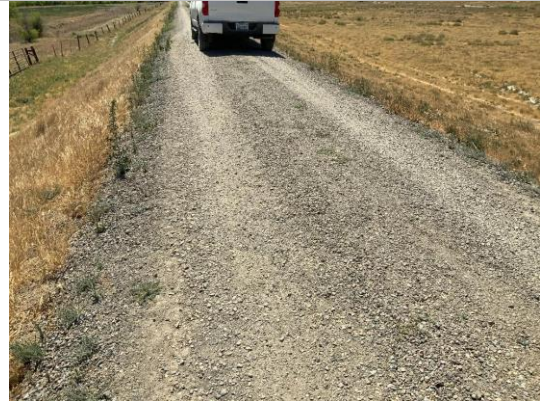
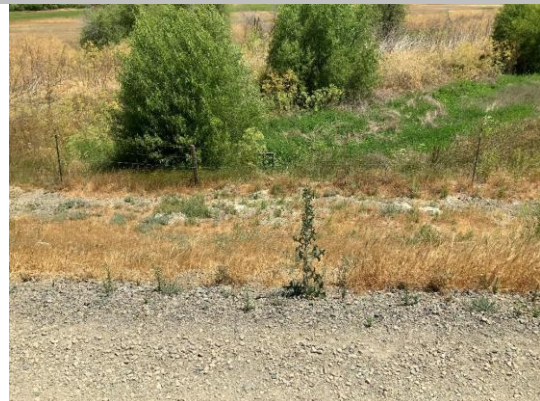
DS_ID:19763
FS_ID:71003
EP_NO: N/A
Repair Type: Non-Urgent
EVAL Issue: 5, Pipe Damage
Crossing Status: Found
UCIP Comments: 09/25/2024 DMP internal video inspection has found moderate pipe defects. Crossing will be monitored until funding becomes available for rehabilitation. (O. Yakimov - DWR UCIP)
06/9/2021 The record remains Non-Urgent. Barbed wire over LS pipe inlet, limited inspection due to inaccessibility. No permit was found authorizing this encroachment. CVFPB will need to review crossing to determine owner. The UCIP inspection was completed with GEI staff, P. Espinoza. (H. Dunn ? GEI)
04/22/2014 Pipe filled with silt on LS toe and should be cleared. (W. Wylie - DWR UCIP)
FIELD_STRUCT_DESC: 24-inch corrugated metal gravity drainage pipe (CMP) through the levee, 16.0 feet below the crown. Flap gate on the waterside (WS) end. Concrete headwall on the landside (LS) end. Concrete U-shaped headwall on the WS end. [Additional Reference(s): DWR Levee Log, 2002, (HLM 8.45). USACE San Joaquin O&M Manual, Unit No. 601, Part No. 1, 1967, Amended in 1978, Revised 20 June 1985, (HLM 8.44). DWR As-Built Specification No. 63-25, Sheet No. 9, 9 May 1963, (HLM 8.44)].

Levee crown looking upstream.

LS view: Toe from crown.

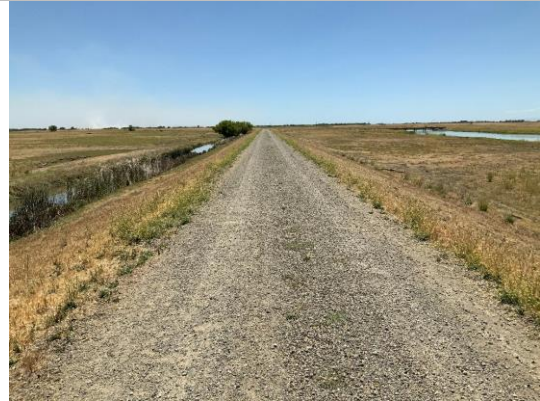
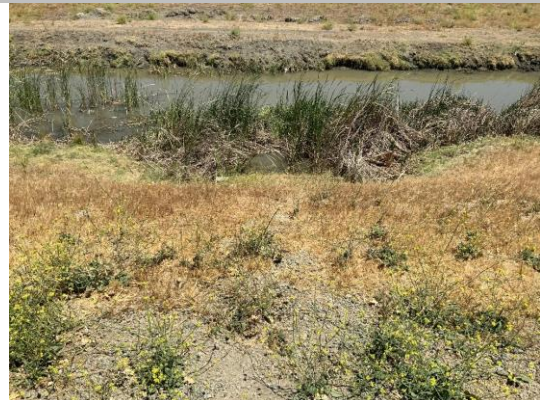
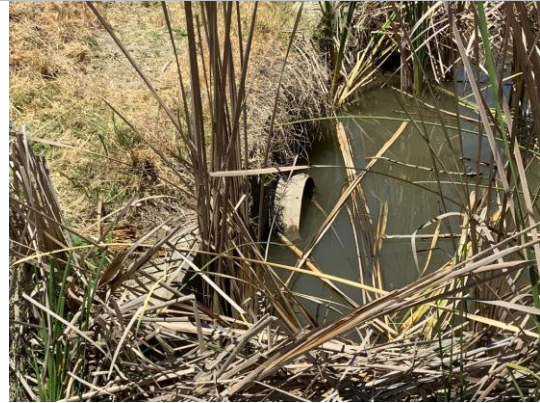
DS_ID:19767
FS_ID:71010
EP_NO: N/A
Repair Type: Non-Urgent
EVAL Issue: 5, Pipe Damage
Crossing Status: Found
UCIP Comments: 09/25/2024 DMP internal video inspection has found moderate pipe defects. Crossing will be monitored until funding becomes available for rehabilitation. (O. Yakimov - DWR UCIP)
06/9/2021 The record remains Non-Urgent. LS pipe inlet is underwater, could not inspect. No permit was found authorizing this encroachment. CVFPB will need to review crossing to determine owner. The UCIP inspection was completed with GEI staff, P. Espinoza. (H. Dunn ? GEI)

Levee crown looking upstream.

LS view: Toe from crown.

LS view: Closeup of pipe inlet at toe, underwater.

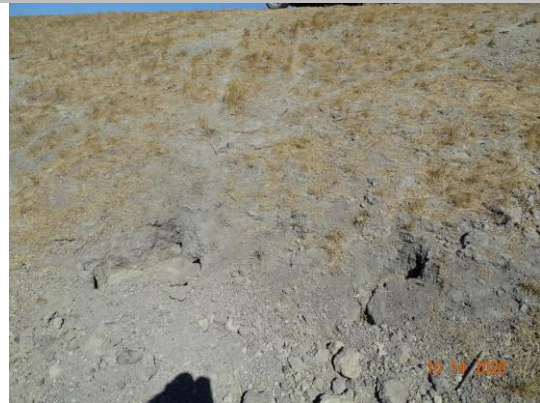
Photo 1 of 1 : FA_2024_NA0010_123_105_20240828_00011.jpg

LM Start	10.10	Rating **	A/W	Issue No.	105
LM End	10.10	Issue Type +	Ma	Location *	WS
Category	Earthen Levee			GPS Latitude/Longitude	
				Start	End
Item	Animal Control			37.194344 °	37.194344 °
				-120.679708 °	-120.679708 °
DWR ID	DWR_NA0010_05_f_2020_105				
Comment Code					
A3 : No rodents visible, but rodent burrows visible; need to backfill and compact or grout burrows.					
Inspector Comment

View of rodent activity in the landside slope. (Fall 2020)

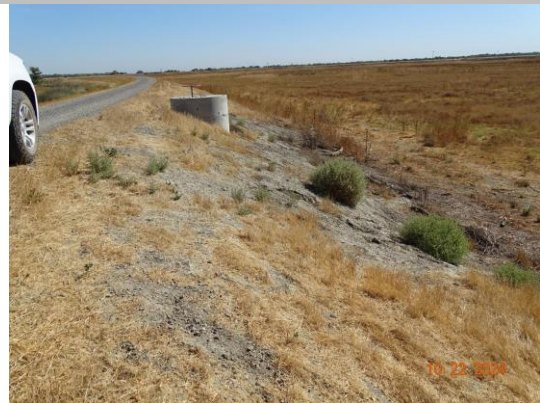
Photo 1 of 1 : FA_2024_NA0010_123_174_20241105_00290.jpg

LM Start	10.45	Rating **	A/W	Issue No.	174
LM End	10.45	Issue Type +	Ma	Location *	WS
Category	Earthen Levee			GPS Latitude/Longitude	
				Start	End
Item	Erosion / Livestock			37.190964 °	37.190964 °
				-120.674862 °	-120.674862 °
DWR ID	DWR_NA0010_05_f_2022_174				
Comment Code					
E4 : Repair the levee slope damaged by livestock and prevent large animal access.					
Inspector Comment

Erosion on the waterside slope from livestock activity. (Fall 2024)

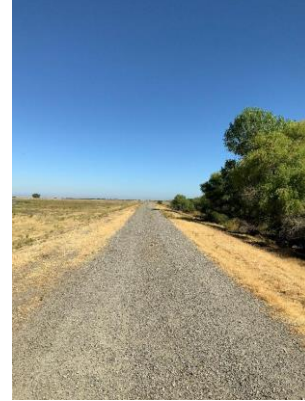
Photo 1 of 3 : UCIP_FA_2024_71012_103968.jpg

Comment Code						
Inspector Comment						
DS_ID:19768 FS_ID:71012 EP_NO: N/A Repair Type: Non-Urgent EVAL Issue: Crossing Status: Found UCIP Comments: 06/22/2021 The record has been upgraded from No Action Needed to Non-Urgent. Crossing appears to be in good condition. No permit was found authorizing this encroachment. CVFPB will need to review crossing to determine owner. The UCIP inspection was completed with GEI staff, H.Dunn. (P.Espinoza ? GEI) FIELD_STRUCT_DESC: [Deadman Drain] 1 of 2: 48-inch corrugated metal gravity drainage pipe (CMP) through the levee, 16.0 feet below the crown. Slide gate in a 60-inch CMP riser unit on the waterside (WS) slope. Concrete U-shaped headwall on each end. Stairs on the landside (LS) slope. [Additional Reference(s): DWR Levee Log, 2002, (HLM 11.45). USACE San Joaquin O&M Manual, Unit No. 601, Part No. 1, 1967, Amended in 1978, Revised 20 June 1985, (HLM 11.48). DWR As-Built Specification No. 61-01, Sheet No. 53, 7 March 1961, (HLM 11.48)]. FS Date: 6/22/2021

View from levee crown.

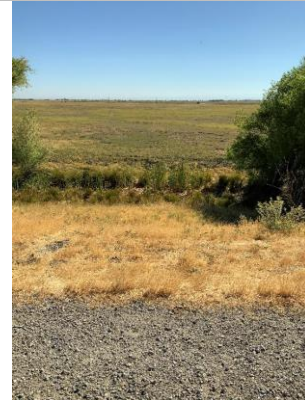
Photo 2 of 3 : UCIP_FA_2024_71012_103970.jpg

LS view of slope from levee crown.

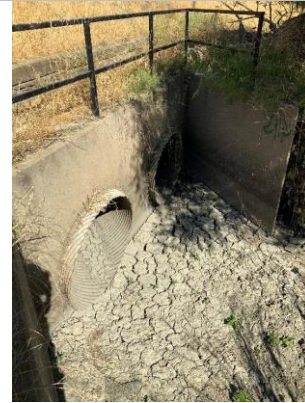
Photo 3 of 3 : UCIP_FA_2024_71012_103973.jpg

LS view: concrete headwall and inlet pipe visible on slope.

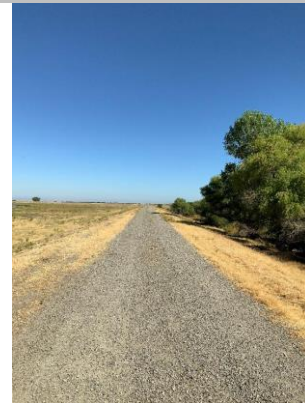
Photo 1 of 3 : UCIP_FA_2024_71013_104487.jpg

DS_ID:19734
FS_ID:71013
EP_NO: N/A
Repair Type: Non-Urgent
EVAL Issue:
Crossing Status: Found
UCIP Comments: 06/22/2021 The record has been upgraded from No Action Needed to Non-Urgent. Crossing appears to be in good condition. No permit was found authorizing this encroachment. CVFPB will need to review crossing to determine owner. The UCIP inspection was completed with GEI staff, P. Espinoza. (H. Dunn ? GEI)
FIELD_STRUCT_DESC: [Deadman Drain] 2 of 2: 48-inch corrugated metal gravity drainage pipe (CMP) through the levee, 16.0 feet below the crown. Slide gate in a 60-inch CMP riser unit on the waterside (WS) slope. Concrete U-shaped headwall on each end. Stairs on the landside (LS) slope. [Additional Reference(s): DWR Levee Log, 2002, (HLM 11.45). USACE San Joaquin O&M Manual, Unit No. 601, Part No. 1, 1967, Amended in 1978, Revised 20 June 1985, (HLM 11.48). DWR As-Built Specification No. 61-01, Sheet No. 53, 7 March 1961, (HLM 11.48)].

Levee crown.

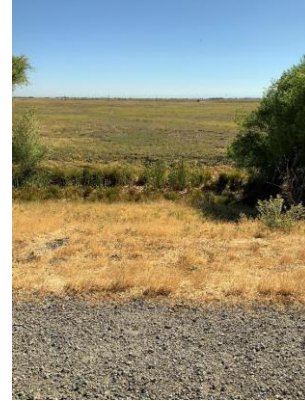
Photo 2 of 3 : UCIP_FA_2024_71013_104489.jpg

LS view: Toe from crown.

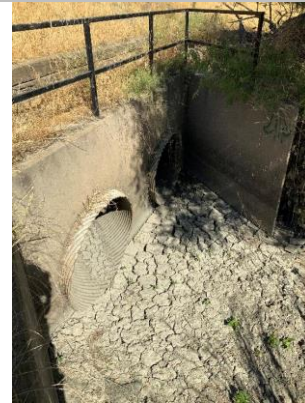
Photo 3 of 3 : UCIP_FA_2024_71013_104486.jpg

LS view: Closeup of inlet at toe.

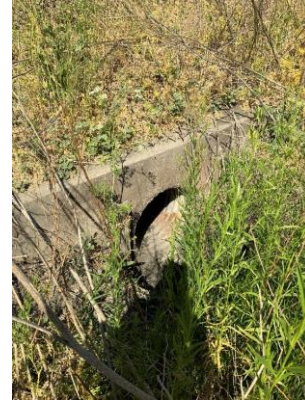
Photo 1 of 2 : UCIP_FA_2024_77929_103981.jpg

DS_ID:19704
FS_ID:77929
EP_NO: N/A
Repair Type: Non-Urgent
EVAL Issue: 11, Maintenance Compliance Issue
Crossing Status: Found
UCIP Comments: 12/20/2022 Record updated from Urgent to Non-Urgent. Pipe has been CIPP lined. LOF of crossing is less or equal to 4. Recommend next video inspection in 5 years. (O.Yakimov - DWR UCIP)
06/22/2021 The record has been upgraded from No Action Needed to Urgent. DWR DMP internal inspection has found pipe integrity issues. LOF of crossing is greater than or equal to 5 and less than 6. Crossing will be monitored until funding becomes available to address the issues. Limited inspection of inlet pipe due to dense vegetation; removal recommended. No permit was found authorizing this encroachment. CVFPB will need to review crossing to determine owner. The UCIP inspection was completed with GEI staff, H.Dunn. (P.Espinoza ? GEI)
FIELD_STRUCT_DESC: 24-inch CIPP-lined corrugated metal gravity drainage pipe (CMP) through the levee, 11.8 feet below the crown. Flap gate on the waterside (WS) end. Concrete headwall on the landside (LS) end. Concrete saddle and apron on the WS end. [Additional Reference(s): DWR Levee Log, 2002, (HLM 11.60). USACE San Joaquin O&M Manual, Unit No. 601, Part No. 1, 1967, Amended in 1978, Revised 20 June 1985, (HLM 11.63). DWR As-Built Specification No. 61-01, Sheet No. 53, 7 March 1961, (HLM 11.63)].

LS view: closeup of concrete headwall and inlet pipe.

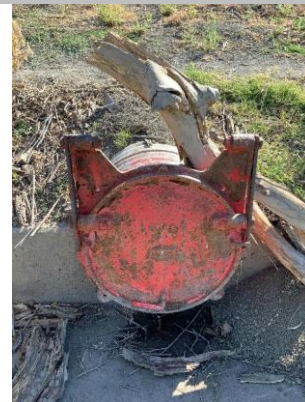
Photo 2 of 2 : UCIP_FA_2024_77929_103979.jpg

WS view: closeup of flapgate.

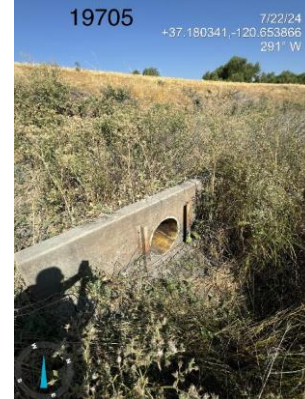
Photo 1 of 3 : UCIP_FA_2024_84537_124875.jpg

Comment Code						
Inspector Comment						
DS_ID:19705 FS_ID:84537 EP_NO: N/A Repair Type: No Action Needed EVAL Issue: Crossing Status: Found UCIP Comments: 07/22/2024 Record updated from Urgent to No Action Needed. Erosion around concrete headwall on WS as well as dense vegetation on LS have been addressed. (M. Thao - DWR UCIP) 12/20/2022 Record remains Urgent. Pipe has been CIPP-lined. LOF of crossing is less or equal to 4. Recommend next video inspection in 5 years. Erosion around concrete headwall on WS needs to be repaired. (O.Yakimov - DWR UCIP) 06/22/2021 The record has been upgraded from No Action Needed to Urgent. DWR DMP internal inspection has found pipe integrity issues. LOF of crossing is between 4.1 and 5. Crossing will be monitored until funding becomes available for rehabilitation. Limited inspection of LS due to dense vegetation; recommend removal. Erosion around concrete headwall on WS, at least 1 foot in depth. No permit was found authorizing this encroachment. CVFPB will need to review crossing to determine owner. The UCIP inspection was completed with GEI staff, H.Dunn. (P.Espinoza - GEI) FIELD_STRUCT_DESC: 24-inch CIPP-lined corrugated metal gravity drainage pipe (CMP) through the levee, 12.5 feet below the crown. Flap gate on the waterside (WS) end. Concrete headwall on the landside (LS) end. Concrete saddle and apron on the WS end. Flashboard attachment on the LS end. [Additional Reference(s): DWR Levee Log, 2002, (HLM 11.98). USACE San Joaquin O&M Manual, Unit No. 601, Part No. 1, 1967, Amended in 1978, Revised 20 June 1985, (HLM 11.99). DWR As-Built Specification No. 61-01, Sheet No. 54, 7 March 1961, (HLM 11.99)]. FS Date: 6/22/2021

LS view: Concrete headwall at toe.

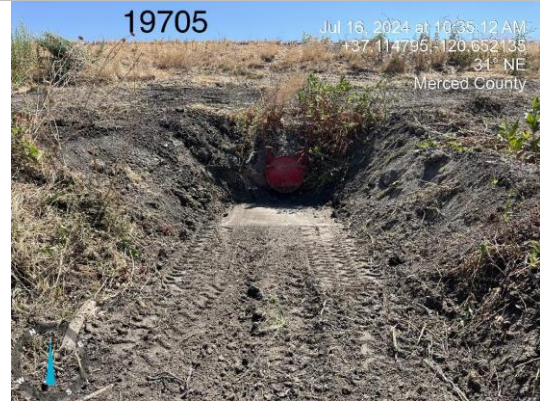
Photo 2 of 3 : UCIP_FA_2024_84537_124873.jpg

WS view: Flap gate at toe; looking toward levee.

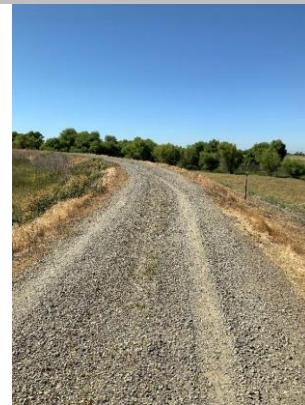
Photo 3 of 3 : UCIP_FA_2024_84537_103982.jpg

View of levee crown.

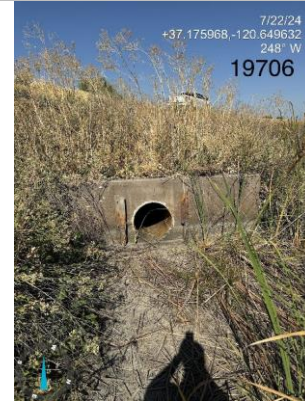
Photo 1 of 3 : UCIP_FA_2024_84538_124876.jpg

Comment Code						
Inspector Comment						
DS_ID:19706 FS_ID:84538 EP_NO: N/A Repair Type: No Action Needed EVAL Issue: Crossing Status: Found UCIP Comments: 07/22/2024 Record updated from Urgent to No Action Needed. Erosion around concrete headwall on WS as well as dense vegetation on LS have been addressed. (M. Thao - DWR UCIP) 12/20/2022 Record remains Urgent. Pipe has been CIPP-lined. LOF of crossing is less or equal to 4. Recommend next video inspection in 5 years. Erosion around flapgate and concrete headwall on waterside needs to be addressed. (O.Yakimov - DWR UCIP) 06/22/2021 The record has been upgraded from No Action Needed to Urgent. DWR DMP internal inspection has found pipe integrity issues. LOF of crossing is between 5 and 6. Crossing will be monitored until funding becomes available to address the issues. Erosion around concrete headwall on WS, at least 1 foot in length. Limited inspection of LS due to vegetation and sediment; recommend removal. No permit was found authorizing this encroachment. CVFPB will need to review crossing to determine owner. The UCIP inspection was completed with GEI staff, H.Dunn. (P.Espinoza - GEI) FIELD_STRUCT_DESC: 24-inch CIPP-lined corrugated metal gravity drainage pipe (CMP) through the levee, 10.2 feet below the crown. Flap gate on the waterside (WS) end. Concrete headwall on the landside (LS) end. Concrete saddle and apron on the WS end. Flashboard attachment on the LS end. Pipe crosses levee at a 45-degree angle. [Additional Reference(s): DWR Levee Log, 2002, (HLM 12.38). USACE San Joaquin O&M Manual, Unit No. 601, Part No. 1, 1967, Amended in 1978, Revised 20 June 1985, (HLM 12.38). DWR As-Built Specification No. 61-01, Sheet No. 54, 7 March 1961, (HLM 12.38)]. FS Date: 6/22/2021

LS view: Concrete headwall on toe.

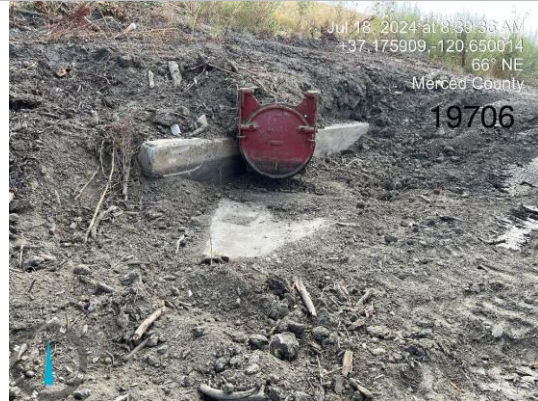
Photo 2 of 3 : UCIP_FA_2024_84538_124874.jpg

WS view: Flap gate and concrete headwall at toe.

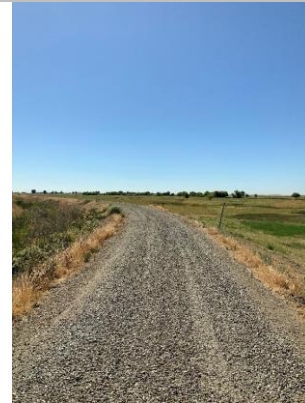
Photo 3 of 3 : UCIP_FA_2024_84538_103999.jpg

View of levee crown.

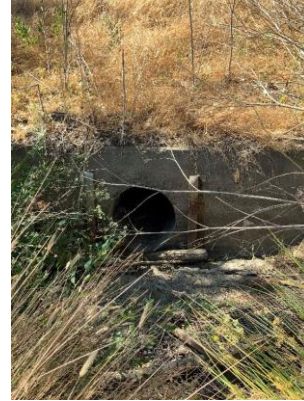
Photo 1 of 3 : UCIP_FA_2024_71018_103998.jpg

Comment Code						
Inspector Comment						
DS_ID:19707 FS_ID:71018 EP_NO: N/A Repair Type: Non-Urgent EVAL Issue: Crossing Status: Found UCIP Comments: 09/18/2023 Pipe was CIPP lined. DMP internal video inspection has found none or minor pipe defects. Recommend next video inspection in 5 years. (O. Yakimov - DWR UCIP) 06/22/2021 The record remains Non-Urgent. DWR DMP internal inspection has found pipe integrity issues. LOF of crossing is between 4.1 and 5. Crossing will be monitored until funding becomes available for rehabilitation. Limited inspection of LS due to vegetation overgrowth; recommend removal. No permit was found authorizing this encroachment. CVFPB will need to review crossing to determine owner. The UCIP inspection was completed with GEI staff, H.Dunn. (P.Espinoza ? GEI)04/22/2014 Sediment buildup in pipe visible from landward side--recommend contacting owner to clear pipe. (W. Wylie - DWR UCIP) FIELD_STRUCT_DESC: 24-inch CIPP-lined corrugated metal gravity drainage pipe (CMP) through the levee, 10.2 feet below the crown. Concrete headwall on the landside (LS) end with flashboards. Concrete saddle and apron on the waterside (WS) end with a flap gate. Metal screen at the LS toe inlet. [Additional Reference(s): DWR Levee Log, 2002, (HLM 12.87). USACE San Joaquin O&M Manual, Unit No. 601, Part No. 1, 1967, Amended in 1978, Revised 20 June 1985, (HLM 12.87). DWR As-Built Specification No. 61-01, Sheet No. 54, 7 March 1961, (HLM 12.87)]. FS Date: 6/22/2021

LS view: concrete headwall and inlet pipe at toe.

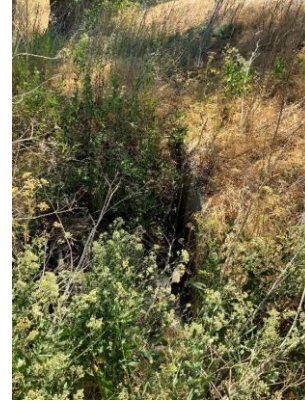
Photo 2 of 3 : UCIP_FA_2024_71018_103996.jpg

LS view: concrete headwall and inlet pipe.

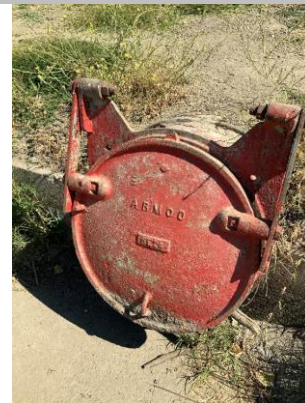
Photo 3 of 3 : UCIP_FA_2024_71018_103995.jpg

WS view: closeup of flapgate.

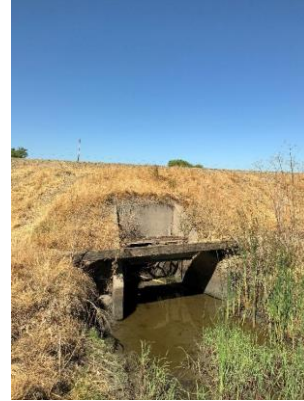
Photo 1 of 2 : UCIP_FA_2024_71019_104014.jpg

Comment Code						
Inspector Comment						
DS_ID:19708 FS_ID:71019 EP_NO: N/A Repair Type: Non-Urgent EVAL Issue: 5, Pipe Damage Crossing Status: Found UCIP Comments: 09/25/2024 DMP internal video inspection has found moderate pipe defects. Crossing will be monitored until funding becomes available for rehabilitation. (O. Yakimov - DWR UCIP) 06/22/2021 The record remains Non-Urgent. Limited inspection of LS due to water around the inlet at the time of survey. LS inlet has sediment buildup, recommend removal. No permit was found authorizing this encroachment. CVFPB will need to review crossing to determine owner. The UCIP inspection was completed with GEI staff, H.Dunn. (P.Espinoza ? GEI)04/22/2014 Some erosion around headwall on the WS toe and there are animal burrows on both slopes. (W. Wylie - DWR UCIP) FIELD_STRUCT_DESC: 48-inch corrugated metal gravity drainage pipe (CMP) through the levee, 10.0 feet below the crown. Flap gate on the waterside (WS) end. Flashboard attachment in a concrete U-shaped headwall on the landside (LS) end. Concrete U-shaped headwall on the WS end. [Additional Reference(s): DWR Levee Log, 2002, (HLM 13.40). USACE San Joaquin O&M Manual, Unit No. 601, Part No. 1, 1967, Amended in 1978, Revised 20 June 1985, (HLM 13.40)]. FS Date: 6/22/2021

LS view from toe: concrete headwall and inlet pipe. Slope visible in background.

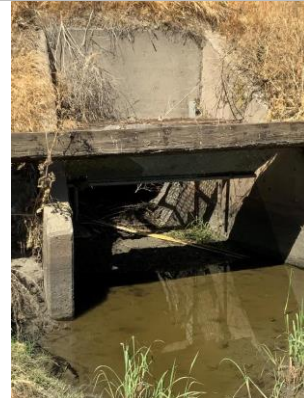
Photo 2 of 2 : UCIP_FA_2024_71019_104015.jpg

LS view from toe: closeup of concrete headwall and inlet.

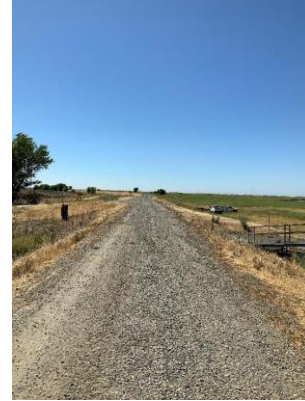
Photo 1 of 3 : UCIP_FA_2024_71020_104016.jpg

Comment Code						
Inspector Comment						
DS_ID:19709 FS_ID:71020 EP_NO: N/A Repair Type: Non-Urgent EVAL Issue: Crossing Status: Indicator Found UCIP Comments: 06/22/2021 The record remains Non-Urgent. Only LS slidegate visible, nothing seen on WS. DWR DMP geophysical study did not confirm presence of pipe through levee. Record will remain in UCIP's inspection records until future Levee Improvement Project can confirm no crossing was found through the levee. No permit was found authorizing this encroachment. CVFPB will need to review crossing to determine owner. The UCIP inspection was completed with GEI staff, H.Dunn. (P.Espinoza ? GEI) 4/22/2014 Pipe not visible and may need to have silt removed from outlet on WS toe. (W. Wylie - DWR UCIP) FIELD_STRUCT_DESC: 24-inch corrugated metal gravity drainage pipe (CMP) through the levee, 10.0 feet below the crown. Flap gate on the waterside (WS) end. Slide gate on a concrete headwall at the landside (LS) toe. Concrete saddle and apron on the WS end. [Additional Reference(s): DWR Levee Log, 2002, (HLM 13.70). USACE San Joaquin O&M Manual, Unit No. 601, Part No. 1, 1967, Amended in 1978, Revised 20 June 1985, (recorded as HLM 14.72, should be 13.72)]. FS Date: 6/22/2021

View of levee crown.

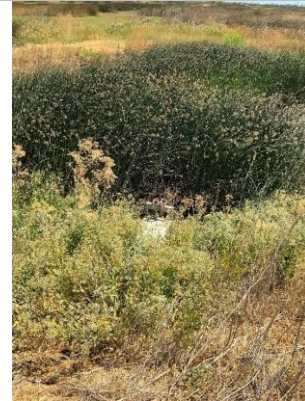
Photo 2 of 3 : UCIP_FA_2024_71020_104017.jpg

LS view of slope to toe from crown.

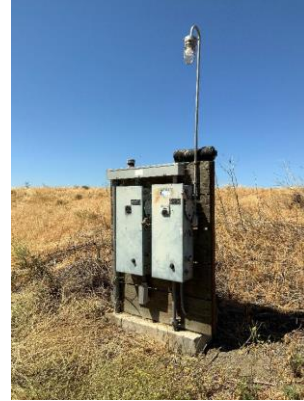
Photo 2 of 3 : UCIP_FA_2024_71021_104472.jpg

LS view: Meters on the toe.

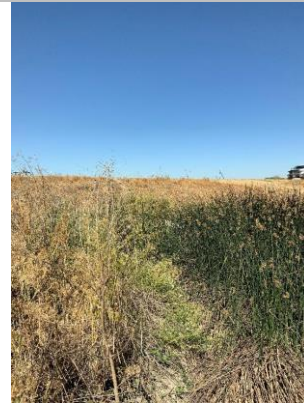
Photo 3 of 3 : UCIP_FA_2024_71021_104473.jpg

LS view: Slope from toe.

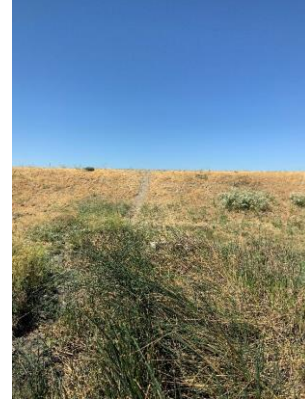
Photo 1 of 3 : UCIP_FA_2024_71023_104025.jpg

Comment Code					
Inspector Comment					
DS_ID:19710 FS_ID:71023 EP_NO: N/A Repair Type: Urgent EVAL Issue: 1, Pipe Integrity Crossing Status: Found UCIP Comments: 09/19/2023 DMP internal video inspection has found severe pipe defects. Crossing will be monitored until funding becomes available to address the issues. (O. Yakimov - DWR UCIP) 06/22/2021 The record has been upgraded from No Action Needed to Urgent. Subsidence along the WS slope that is at least 1 foot in length. Limited inspection of LS due to vegetation; recommend removal. No permit was found authorizing this encroachment. CVFPB will need to review crossing to determine owner. The UCIP inspection was completed with GEI staff, H.Dunn. (P.Espinoza ? GEI) FIELD_STRUCT_DESC: 24-inch corrugated metal gravity drainage pipe (CMP) through the levee, 12.4 feet below the crown. Flap gate on the waterside (WS) end. Concrete headwall on each end. [Additional Reference(s): DWR Levee Log, 2002, (HLM 13.84). USACE San Joaquin O&M Manual, Unit No. 601, Part No. 1, 1967, Amended in 1978, Revised 20 June 1985, (HLM 13.83). DWR As-Built Specification No. 61-01, Sheet No. 55, 7 March 1961, (HLM 13.83)]. FS Date: 6/22/2021

LS view of slope from toe.

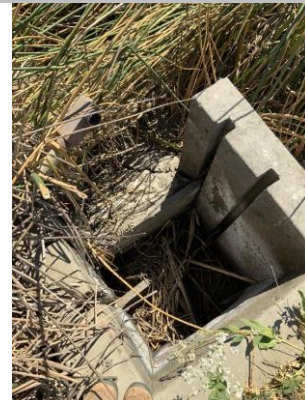
Photo 2 of 3 : UCIP_FA_2024_71023_104026.jpg

LS view: concrete wier intake structure at toe.

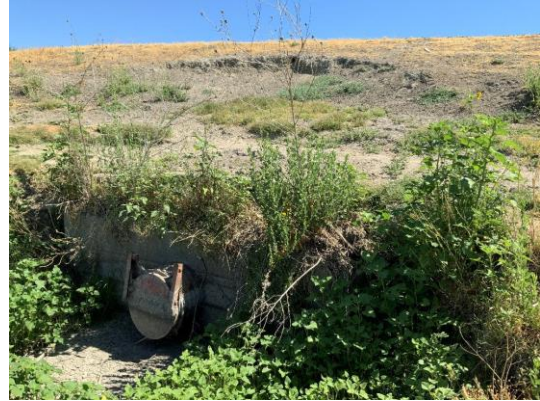
Photo 3 of 3 : UCIP_FA_2024_71023_104024.jpg

WS view from toe: concrete headwall, flapgate, and outlet pipe.
Subsidence along slope in background.

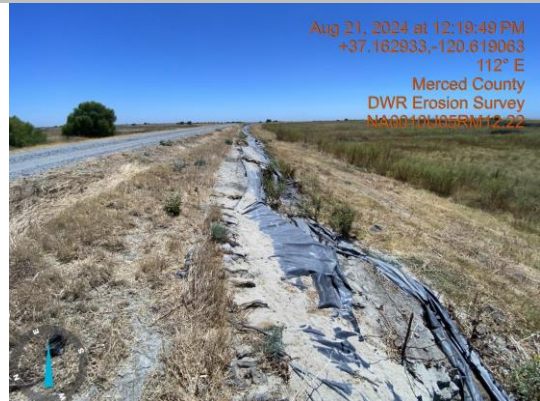
Photo 1 of 2 : SJR2024_NA0010U05RM12.22_2.JPG

LM Start	14.31	Rating **	U	Issue No.	3
LM End	14.54	Issue Type +	Ma	Location *	WS
Category	Supplemental		GPS Latitude/Longitude		
			Start	End	
Item	DWR Erosion Survey		37.162949 °	37.162949 °	
			-120.619138 °	-120.619138 °	
DWR ID	NA0010U05RM12.22

8/21/2024: From 2023 to present, significant changes were observed during the annual survey, length increased to 1200 feet and scarp ranges from 4-6 feet.

8/10/2023: Significant changes were observed during the annual survey, scarp increased to 6 feet and length to 500 feet.

08/03/2022: No significant changes were observed since the previous inspection.

07/21/2021: This site was discovered during the DWR Spring 2021 Levee Inspections. There is a series of erosion pockets along the lower levee slope and toe, ranging from 3 ft in length to 15 ft and 2 ft to 7 ft in scarp height. There are several of rodent holes on the entire levee slope.

8/21/2024: View of the erosion under wavewash protection.

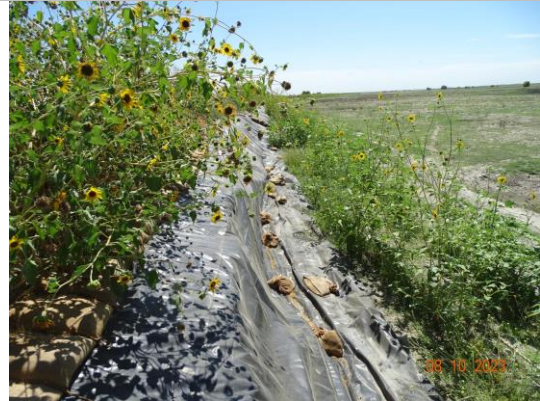
Photo 2 of 2 : SJR2024_NA0010U05RM12.22_4.JPG

LM Start	14.31	Rating **	U	Issue No.	3 (cont)
LM End	14.54	Issue Type +	Ma	Location *	WS
Category	Supplemental			GPS Latitude/Longitude	
				Start	End
Item	DWR Erosion Survey			37.162949°	37.162949°
				-120.619138°	-120.619138°
DWR ID	NA0010U05RM12.22

8/10/2023: View of the erosion under wavewash protection.
