Flood Control Project Maintenance Levee Inspections

Fall 2024 Levee Maintenance Deficiency Summary Report

San Joaquin River Basin

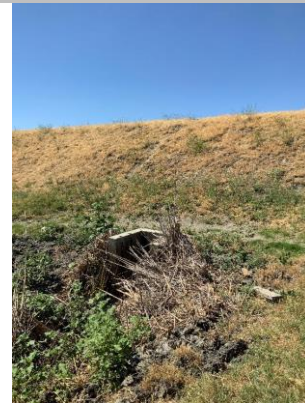
Photo 1 of 1 : UCIP_FA_2024_71024_104033.jpg

DS_ID:19711
 FS_ID:71024
 EP_NO: N/A
 Repair Type: Non-Urgent
 EVAL Issue: 5, Pipe Damage
 Crossing Status: Found
 UCIP Comments: 09/25/2024 DMP internal video inspection has found moderate pipe defects. Crossing will be monitored until funding becomes available for rehabilitation. (O. Yakimov - DWR UCIP)
 06/22/2021 The record has been upgraded from No Action Needed to Non-Urgent. Dense vegetation on LS; recommend removal. No permit was found authorizing this encroachment. CVFPB will need to review crossing to determine owner. The UCIP inspection was completed with GEI staff, H.Dunn. (P.Espinoza ? GEI)
 FIELD_STRUCT_DESC: 24-inch corrugated metal gravity drainage pipe (CMP) through the levee, 12.5 feet below the crown. Flap gate on the waterside (WS) end. Concrete headwall on each end. Concrete weir inlet structure on the landside (LS) toe. [Additional Reference(s): DWR Levee Log, 2002, (HLM 14.44). USACE San Joaquin O&M Manual, Unit No. 601, Part No. 1, 1967, Amended in 1978, Revised 20 June 1985, (HLM 14.44)]

LS view of slope from toe: concrete headwall visible in background.

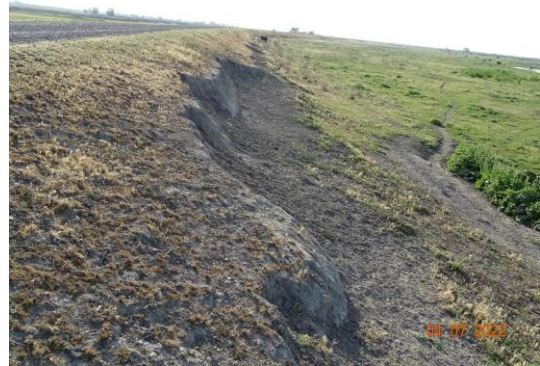
Photo 1 of 1 : FA_2024_NA0010_123_119_20240828_00017.jpg

LM Start	14.47	Rating **	U	Issue No.	119
LM End	14.49	Issue Type +	Ma	Location *	WS
Category	Earthen Levee			GPS Latitude/Longitude	
				Start	End
Item	Erosion / Bank Caving			37.162647 °	37.162540 °
				-120.618376 °	-120.618091 °
DWR ID	DWR_NA0010_05_s _ 2021_119				
Comment Code					
E2 : Schedule repair of erosion site prior to the next inspection.					
Inspector Comment					
Slope erosion on the waterside slope. Possibly caused by livestock.

Looking upstream along the waterside slope at erosion spots. (Spring 2022)

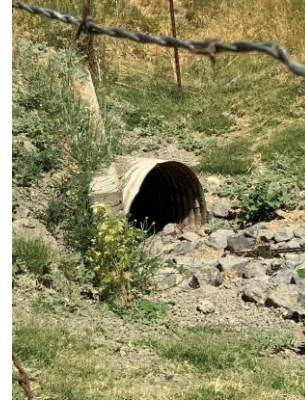
Photo 1 of 3 : UCIP_FA_2024_81020_104051.jpg

Comment Code						
Inspector Comment						
DS_ID:19712 FS_ID:81020 EP_NO: N/A Repair Type: Urgent EVAL Issue: 1, Pipe Integrity Crossing Status: Found UCIP Comments: 09/19/2023 Record updated from Non-Urgent to Urgent. DMP internal video inspection has found severe pipe defects. Crossing will be monitored until funding becomes available to address the issues. (O. Yakimov - DWR UCIP) 06/22/2021 The record remains Non-Urgent. Limited inspection on LS due to barbed wire and access issues. Build up of sediment at WS outlet pipe and LS inlet pipe; recommend removal. Some erosion along the WS slope, less than 1 foot. No permit was found authorizing this encroachment. CVFPB will need to review crossing to determine owner. The UCIP inspection was completed with GEI staff, H.Dunn. (P.Espinoza ? GEI)04/23/2014 Minor erosion at headwall on WS toe. (W. Wylie - DWR UCIP) FIELD_STRUCT_DESC: 36-inch corrugated metal gravity drainage pipe (CMP) through the levee, 11.9 feet below the crown. Flap gate on the waterside (WS) end. Concrete headwall on each end. [Additional Reference(s): DWR Levee Log, 2002, (HLM 15.08). USACE San Joaquin O&M Manual, Unit No. 601, Part No. 1, 1967, Amended in 1978, Revised 20 June 1985, (HLM 15.09)]. FS Date: 6/22/2021

LS view: Closeup of inlet pipe.

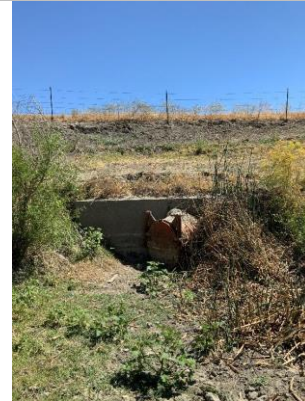
Photo 2 of 3 : UCIP_FA_2024_81020_104048.jpg

WS view from toe: concrete headwall, flapgate, and outlet pipe. Erosion along slope visible in background.

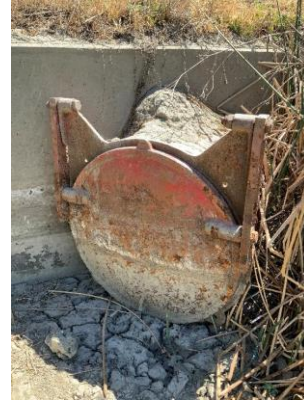
Photo 3 of 3 : UCIP_FA_2024_81020_104049.jpg

WS view from toe: closeup of flapgate and outlet pipe.

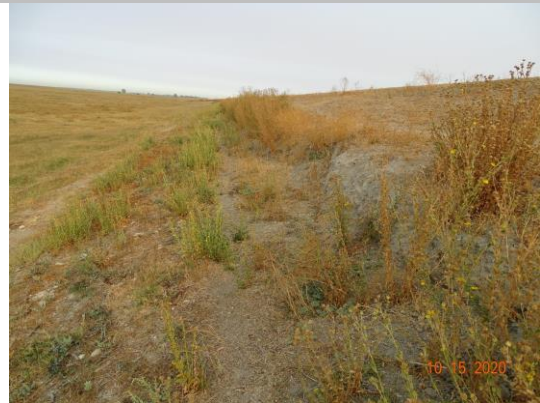
Photo 1 of 1 : FA_2024_NA0010_123_110_20240828_00012.jpg

LM Start	15.21	Rating **	M	Issue No.	110
LM End	15.26	Issue Type +	Ma	Location *	WS
Category	Earthen Levee			GPS Latitude/Longitude	
				Start	End
Item	Erosion / Bank Caving			37.155782 °	37.155337 °
				-120.608075 °	-120.607449 °
DWR ID	DWR_NA0010_05_f_2020_110				
Comment Code					
E2 : Schedule repair of erosion site prior to the next inspection.					
Inspector Comment

Erosion along the waterside slope. (Fall 2020)

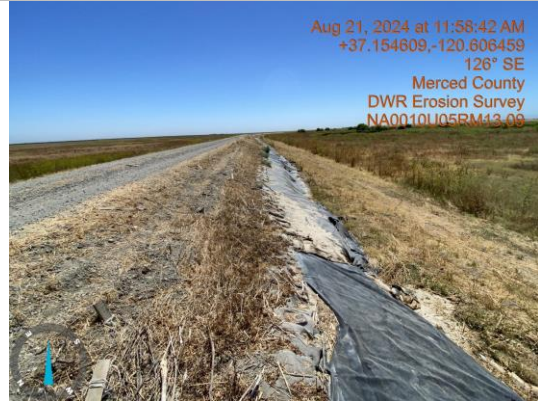
Photo 1 of 2 : SJR2024_NA0010U05RM13.09_2.JPG

Comment Code					
Inspector Comment					
Site ID: NA0010U05RM13.09					
8/21/2024: From 2023 to present, significant changes were observed during the annual survey, length increased to 1000 feet and scarp range is 4-6 feet.					
8/10/2023: From 2022 to present, significant changes were observed during the annual survey, scarp increased to 6 feet.					
08/03/2022: From 2021 to present, no significant changes were observed during the annual survey. The erosion length was updated to 80 ft based on more accurate field measurements.					
08/19/2020: This site was discovered during the DWR Spring 2020 Levee Inspections. There is a 20-ft long and an 8-ft long erosion pocket, with scarp heights of up to 3 ft. The erosion has cut into the levee prism. There are signs of rodent and cattle activity.

8/21/2024: View of the erosion looking upstream under wavewash protection.

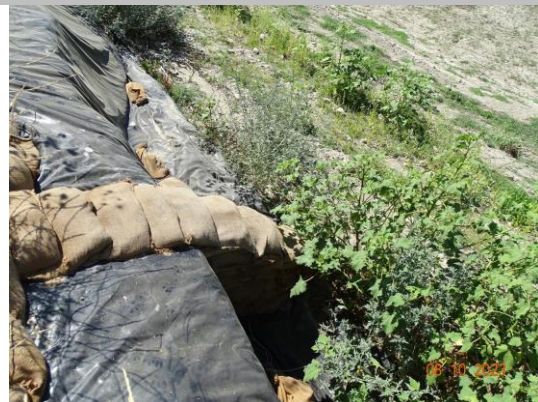
Photo 2 of 2 : SJR2024_NA0010U05RM13.09_6.JPG

8/10/2023: View of the erosion under wavewash protection.

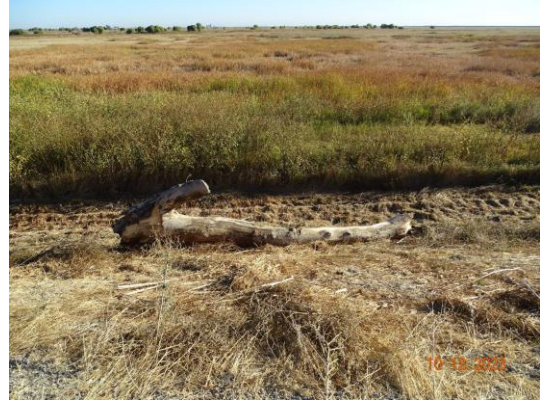
Photo 1 of 1 : FA_2024_NA0010_123_153_20240828_00035.jpg

LM Start	15.37	Rating **	A/W	Issue No.	153
LM End	15.37	Issue Type +	En	Location *	LS
Category	Earthen Levee			GPS Latitude/Longitude	
				Start	End
Item	Encroachments			37.154232°	37.154232°
				-120.605883°	-120.605883°
DWR ID	DWR_NA0010_05_f_2023_153				
Comment Code					
PR : Prunings					
Inspector Comment

Cut tree limb left on the landside toe. (Fall 2023)

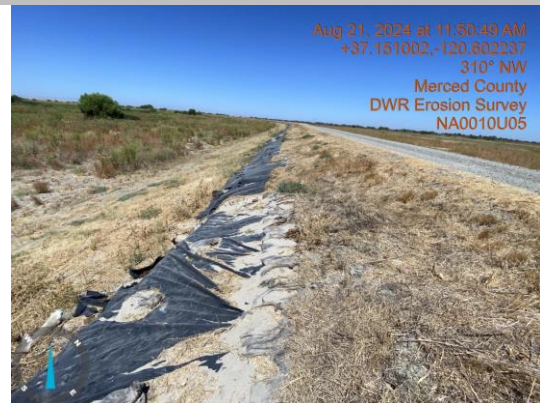
Photo 1 of 1 : SJR2024_NA0010U05RM13.42_2.jpg

LM Start	15.64	Rating **	U	Issue No.	4
LM End	15.72	Issue Type +	Ma	Location *	WS
Category	Supplemental			GPS Latitude/Longitude	
				Start	End
Item	DWR Erosion Survey			37.150945 °	37.150945 °
				-120.602185 °	-120.602185 °
DWR ID	NA0010U05RM13.42				
Comment Code					
Inspector Comment					
Site ID: NA0010U05RM13.42 08/21/2024: The site was discovered by the LMA and visited during the annual field survey. There is a 5-6 ft scarp, vertical in some locations, running along the bank. The levee slope has plastic (wavewash) protecting from from making the erosion worse.

8/21/2024: View of erosion under plastic protection (wavewash).

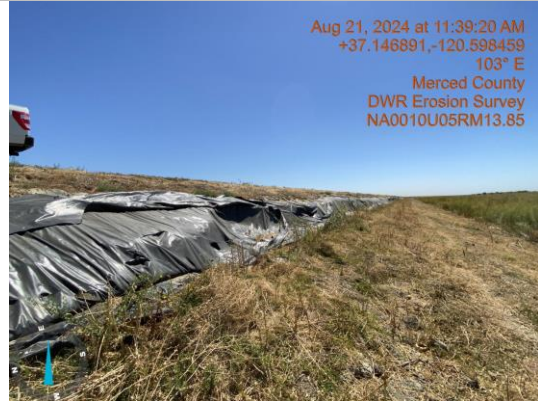
Photo 1 of 2 : SJR2024_NA0010U05RM13.85_4.JPG

8/21/2024: From 2023 to present, significant changes were observed during the annual survey, length was increased to 2000 feet and scarp range is 4-6 feet.

09/10/2019: The erosion has become worse during the past 2 flood seasons. The erosion length has increased to approximately 200 ft from 55 ft. Signs of animal activity were observed.

8/21/2024: View of the erosion under wavewash protection.

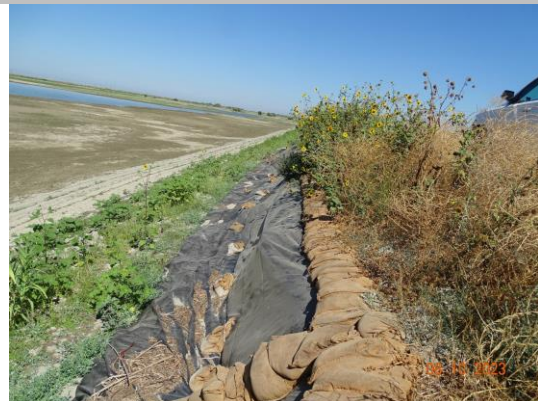
Photo 2 of 2 : SJR2024_NA0010U05RM13.85_7.JPG

8/10/2023: Significant changes were observed during the annual survey, scarp was increased 6 feet.

8/10/2023: View of the erosion under wavewash protection.

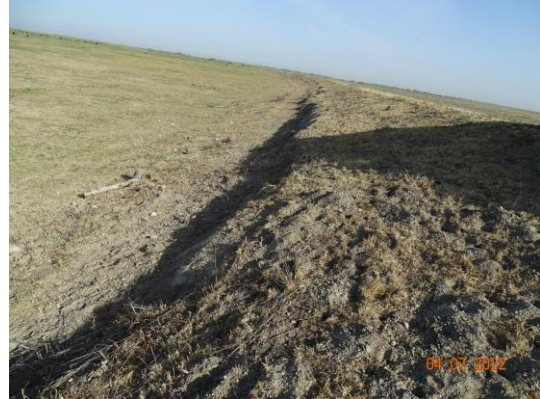
Photo 1 of 1 : FA_2024_NA0010_123_173_20240828_00049.jpg

LM Start	16.34	Rating **	M	Issue No.	173
LM End	16.34	Issue Type +	Ma	Location *	WS
Category	Earthen Levee			GPS Latitude/Longitude	
				Start	End
Item	Erosion / Livestock			37.143141 °	37.143141 °
				-120.595183 °	-120.595183 °
DWR ID	DWR_NA0010_05_s_2022_173				
Comment Code					
E4 : Repair the levee slope damaged by livestock and prevent large animal access.					
Inspector Comment

Looking downstream along the waterside slope at erosion from livestock activity. (Spring 2022)

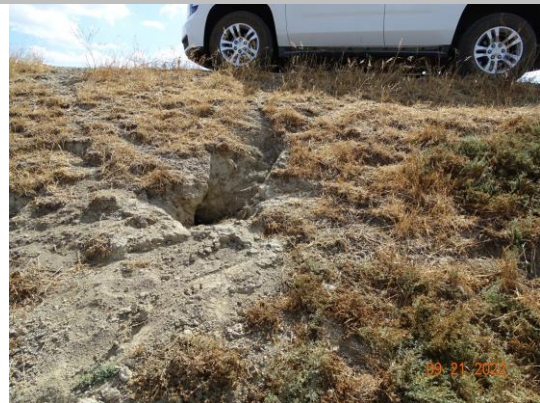
LS view: Inside pipe at LS toe

Photo 3 of 3 : UCIP_FA_2024_83236_90559.jpg

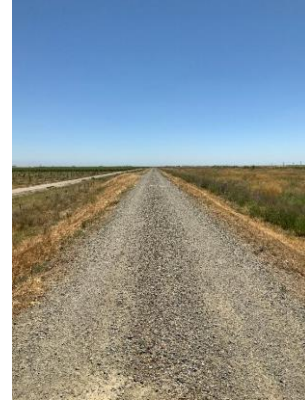
Pipe and flapgate visible on WS toe

Overview of levee crown, looking US

**Flood Control Project Maintenance
Levee Inspections****Levee Inspection Report By Mile - Fall 2024****Lower San Joaquin Levee District**

Photo 2 of 3 : UCIP_FA_2024_83238_90570.jpg

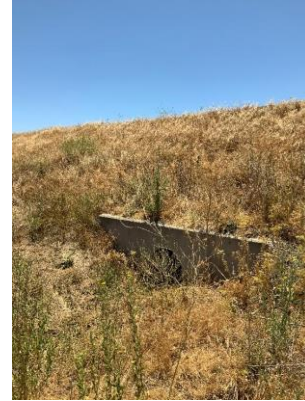
Waterway	Bank	Unit Miles	Inspection Start/End	Inspector
Unit No. 01 San Joaquin River	Right	22.52	10/21/2024 10/24/2024	Corey Fujitani

Comment Code					
Inspector Comment					
DS_ID:19589 FS_ID:70644 EP_NO: N/A Repair Type: No Action Needed EVAL Issue: Crossing Status: Found UCIP Comments: 09/15/2023 Record updated from Non-Urgent to No Action Needed. Pipe was CIPP lined. DMP internal video inspection has found none or minor pipe defects. Recommend next video inspection in 5 years. (O. Yakimov - DWR UCIP) 10/06/2020 Record remains Non-Urgent. DWR DMP has found integrity issues, LOF between 4 and 5. Crossing will be monitored until funding becomes available for rehabilitation. No permit was found authorizing this encroachment. CVFPB will need to review crossing to determine owner. Dense vegetation was found along the WS and LS toe. Recommend removing vegetation along the pipe alignment. Based on the 2014 photos, the LS toe appears to be heavily silted up. Recommend removing silt to increase flow capacity and meet pipe design capacity. (B. Singh - GEI, O. Magana - DWR UCIP) 04/08/2014 Heavy sediment buildup in pipe at LS toe. (DWR UCIP - W. Wylie) FIELD_STRUCT_DESC: 24-inch CIPP-lined corrugated metal (CM) gravity drainage pipe through the levee, 13.6 feet below the crown. Flap gate on the waterside (WS) end. Brass cap No. 108 bench mark (BM) on the headwall on the landside (LS). [Additional Reference(s): DWR Levee Log, 2002, (HLM 1.70). USACE San Joaquin O&M Manual, Unit No. 601, Part No. 1, (SJR601.1), 1967, Revised 25 May 2011, (HLM 1.69)]. FS Date: 10/6/2020

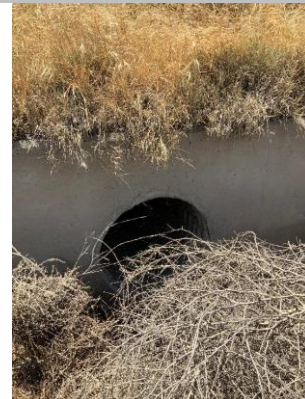
LS view: Pipe and concrete headwall partially visible at LS toe

Comment Code

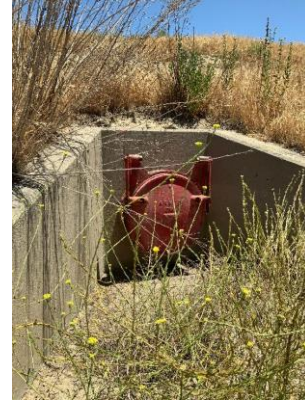
**Flood Control Project Maintenance
Levee Inspections****Levee Inspection Report By Mile - Fall 2024****Lower San Joaquin Levee District**

* Location LS : Land Side N/A : Not Applicable WS : Water Side CR : Crown		** Rating A : Acceptable M : Minimally Acceptable U : Unacceptable N : Not Inspected/Rated C : Corrected A/W : Acceptable but Monitor & Maintain		+ Issue Type Ma : Maintenance Deficiency Ob : Design & System Obsolescence En : Enforcement	
--	--	---	--	---	--

LM Start	1.95	Rating **	A	Issue No.	1195 (cont)
LM End	1.95	Issue Type +	Ma	Location *	
Category	Supplemental			GPS Latitude/Longitude	
				Start	End
Item	DWR UCIP LMA Responsibility			37.334377 °	37.334377 °
				-120.940397 °	-120.940397 °
DWR ID	19591

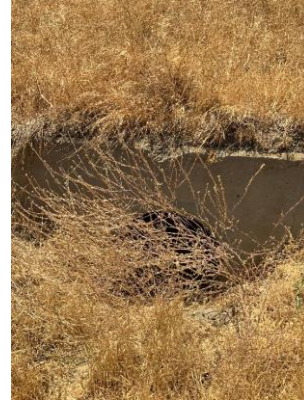
Photo 3 of 3 : UCIP_FA_2024_83239_90613.jpg

LS view: View toward LS pipe and headwall from levee crown

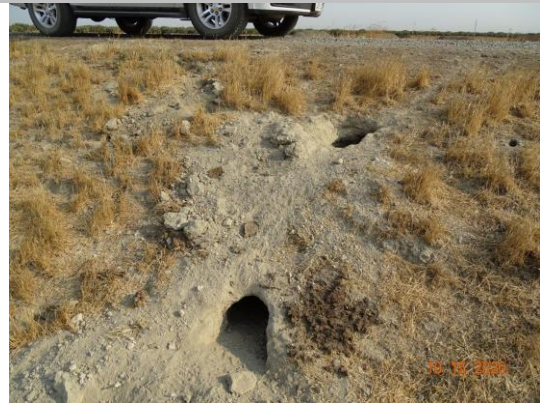
No Photos

Levee Inspection Report By Mile - Fall 2024

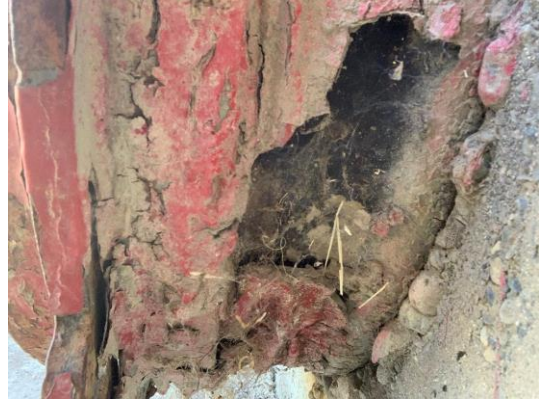
Waterway	Bank	Unit Miles	Inspection Start/End	Inspector
Unit No. 01 San Joaquin River	Right	22.52	10/21/2024 10/24/2024	Corey Fujitani

Photo 3 of 3 : UCIP_FA_2024_77843_90623.jpg

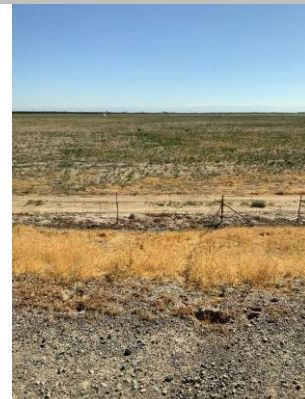
Photo 2 of 3 : UCIP_FA_2024_84939_104164.jpg

LS view: Toe from crown.

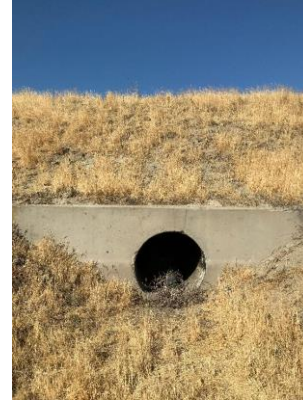
Photo 3 of 3 : UCIP_FA_2024_84939_104161.jpg

LS view: Slope and headwall from toe.

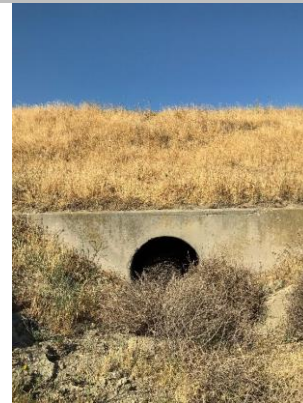
Photo 1 of 2 : UCIP_FA_2024_84967_104168.jpg

DS_ID:19783
FS_ID:84967
EP_NO: N/A
Repair Type: No Action Needed
EVAL Issue:
Crossing Status: Found
UCIP Comments: 10/07/2024 Record updated from Non-Urgent to No Action Needed. Removed code 12b since pipe is drainage and record source is Levee Log and O&M. Removed code 11 since vegetation is not maintenance of the pipe. (M. Thao - DWR UCIP 10/23/2021 The record has been upgraded from No Action Needed to Non-Urgent. DWR DMP internal inspection has not found pipe integrity issues. LOF of crossing is less or equal to 4.0. Recommend next video inspection in 5 years. Limited inspection of LS pipe inlet due to tumbleweeds, recommend removal. No permit was found authorizing this encroachment. CVFPB will need to review crossing to determine owner. The UCIP inspection was completed with GEI staff, P. Espinoza. (H. Dunn ? GEI)
FIELD_STRUCT_DESC: 36-inch corrugated metal gravity drainage pipe (CMP) through the levee, 10.6 feet below the crown. Flap gate on the waterside (WS) end. Concrete headwall on each end. [Additional Reference(s): DWR Levee Log, 2002, (HLM 20.18). USACE San Joaquin O&M Manual, Unit No. 601, Part No. 1, 1967, Amended in 1978, Revised 20 June 1985, (HLM 20.18). DWR As-Built Specification No. 64-01, Sheet No. 4, 6 November 1963, (HLM 20.18)].

LS view: Slope and headwall from toe.

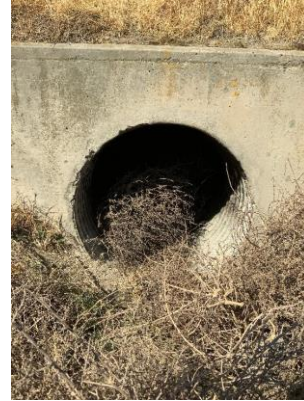
Photo 2 of 2 : UCIP_FA_2024_84967_104169.jpg

LS view: Closeup of pipe inlet at toe.

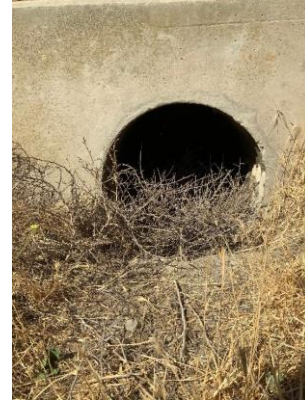
Photo 1 of 1 : UCIP_FA_2024_84968_104180.jpg

Comment Code					
Inspector Comment					
DS_ID:19784 FS_ID:84968 EP_NO: N/A Repair Type: No Action Needed EVAL Issue: Crossing Status: Found UCIP Comments: 10/07/2024 Record updated from Non-Urgent to No Action Needed. Removed code 12b since pipe is drainage and record source is Levee Log and O&M. Removed code 11 since vegetation is not maintenance of the pipe. (M. Thao - DWR UCIP 12/20/2022) Record updated from Urgent to Non-Urgent. Pipe has been CIPP-lined. LOF of crossing is less or equal to 4. Recommend next video inspection in 5 years. (O. Yakimov - DWR UCIP 06/23/2021 The record has been upgraded from Non-Urgent to Urgent. DWR DMP internal inspection has found pipe integrity issues. LOF of crossing is greater than or equal to 5 and less than 6. Crossing will be monitored until funding becomes available to address the issues. Some tumbleweed buildup at LS pipe inlet, recommend removal. No permit was found authorizing this encroachment. CVFPB will need to review crossing to determine owner. The UCIP inspection was completed with GEI staff, P. Espinoza. (H. Dunn ? GEI 04/23/2014 Dense vegetation limits the inspector's visibility to identify signs of pipe failure (leaks) along the landward slope. Recommend removing vegetation along pipe alignment to conduct proper inspection of structure. (W. Wylie - DWR UCIP) FIELD_STRUCT_DESC: 24-inch CIPP-lined corrugated metal gravity drainage pipe (CMP) through the levee, 10.5 feet below the crown. Flap gate on the waterside (WS) end. Concrete headwall on the landside (LS) end. Concrete U-shaped headwall on the WS end. [Additional Reference(s): DWR Levee Log, 2002, (HLM 20.58). USACE San Joaquin O&M Manual, Unit No. 601, Part No. 1, 1967, Amended in 1978, Revised 20 June 1985, (HLM 20.59). DWR As-Built Specification No. 64-01, Sheet No. 4, 6 November 1963, (HLM 20.59)]. FS Date: 6/23/2021

LS view: Tumbleweeds in pipe inlet at toe.

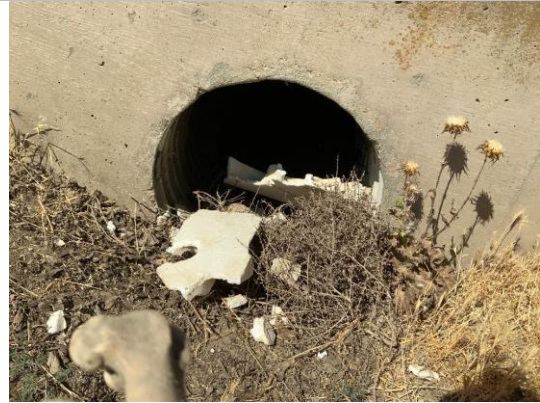
Photo 1 of 2 : UCIP_FA_2024_77909_104182.jpg

Comment Code					
Inspector Comment					
DS_ID:19785 FS_ID:77909 EP_NO: N/A Repair Type: Non-Urgent EVAL Issue: 11, Maintenance Compliance Issue Crossing Status: Found UCIP Comments: 12/20/2022 Record updated from Urgent to Non-Urgent. Pipe has been CIPP-lined. LOF of crossing is less or equal to 4. Recommend next video inspection in 5 years. (O.Yakimov - DWR UCIP) 06/23/2021 The record is being upgraded from Non-Urgent to Urgent. DWR DMP internal inspection has found pipe integrity issues. LOF of crossing is greater than or equal to 5 and less than 6. Crossing will be monitored until funding becomes available to address the issues. Tumbleweed and debris covering LS pipe inlet, recommend removal. No permit was found authorizing this encroachment. CVFPB will need to review crossing to determine owner. The UCIP inspection was completed with GEI staff, P. Espinoza. (H. Dunn ? GEI) 04/23/2014 Dense vegetation limits the inspector's visibility to identify signs of pipe failure (leaks) along the landward slope. Recommend removing vegetation along pipe alignment to conduct proper inspection of structure. (W. Wylie - DWR UCIP) FIELD_STRUCT_DESC: 24-inch CIPP-lined corrugated metal gravity drainage pipe (CMP) through the levee, 11.8 feet below the crown. Flap gate on the waterside (WS) end. Concrete headwall on the landside (LS) end. Concrete U-shaped headwall on the WS end. [Additional Reference(s): DWR Levee Log, 2002, (HLM 21.07). USACE San Joaquin O&M Manual, Unit No. 601, Part No. 1, 1967, Amended in 1978, Revised 20 June 1985, (HLM 21.08). DWR As-Built Specification No. 64-01, Sheet No. 5, 6 November 1963, (HLM 21.08)]. FS Date: 6/23/2021 10:19:41 AM

LS view: Debris inside pipe inlet at toe.

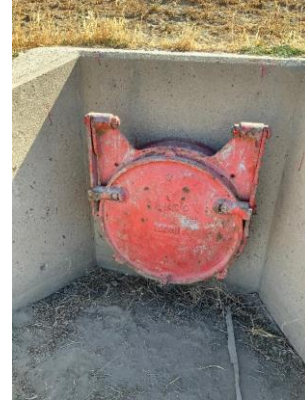
Photo 2 of 2 : UCIP_FA_2024_77909_104187.jpg

WS view: Closeup of flapgate at toe.

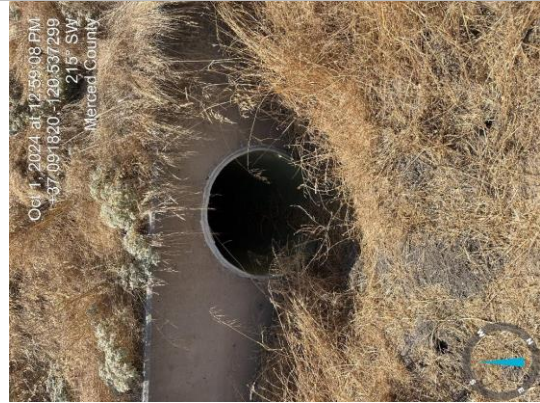
Photo 1 of 3 : UCIP_FA_2024_84909_125390.jpg

Comment Code						
Inspector Comment						
DS_ID:19786 FS_ID:84909 EP_NO: N/A Repair Type: No Action Needed EVAL Issue: Crossing Status: Found UCIP Comments: 10/01/2024 Record has been updated from Non-Urgent to No Action Needed. Sand buildup around WS flap gate has been cleared and no hole is present on flap gate. (M. Thao - DWR UCIP) 09/26/2024 Record has been updated from Urgent to Non-Urgent. Pipe has been CIPP-lined. DMP internal video inspection has found none or minor pipe defects. (M. Thao - DWR UCIP) 06/23/2021 The record has been upgraded from Non-Urgent to Urgent. DWR DMP internal inspection has found pipe integrity issues. LOF of crossing is is greater than or equal to 5 and less than 6. Crossing will be monitored until funding becomes available to address the issues. Potential hole in WS flapgate. Sand buildup around WS flapgate preventing it from opening easily, recommend removal. No permit was found authorizing this encroachment. CVFPB will need to review crossing to determine owner. The UCIP inspection was completed with GEI staff, P. Espinoza. (H. Dunn ? GEO) 04/23/2014 Dense vegetation limits the inspector's visibility to identify signs of pipe failure (leaks) along the landward slope. Recommend removing vegetation along pipe alignment to conduct proper inspection of structure. (W. Wylie - DWR UCIP) FIELD_STRUCT_DESC: 36-inch CIPP-lined corrugated metal gravity drainage pipe (CMP) through the levee, 12.7 feet below the crown. Flap gate on the waterside (WS) end. Concrete headwall on the landside (LS) end. Concrete U-shaped headwall on the WS end. [Additional Reference(s): DWR Levee Log, 2002, (HLM 21.43). USACE San Joaquin O&M Manual, Unit No. 601, Part No. 1, 1967, Amended in 1978, Revised 20 June 1985, (HLM 21.42). DWR As-Built Specification No. 64-01, Sheet No. 5, 6 November 1963, (HLM 21.42)]. FS Date: 6/23/2021

LS view: Concrete headwall and pipe inlet; pipe has been CIPP-lined.

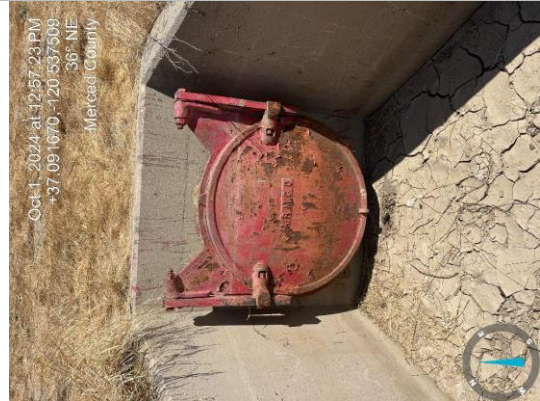
Photo 2 of 3 : UCIP_FA_2024_84909_125389.jpg

WS view: Concrete headwall and flap gate at toe.

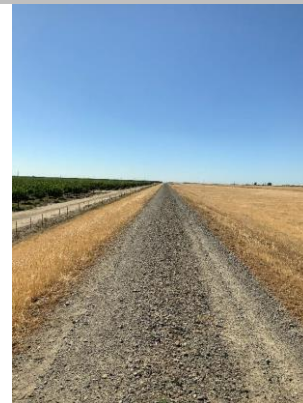
Photo 3 of 3 : UCIP_FA_2024_84909_104192.jpg

Levee crown.

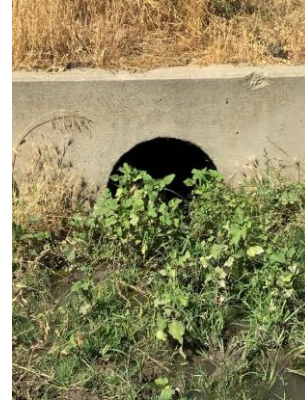
Photo 1 of 2 : UCIP_FA_2024_84977_104197.jpg

Comment Code						
Inspector Comment						
DS_ID:19787 FS_ID:84977 EP_NO: N/A Repair Type: No Action Needed EVAL Issue: Crossing Status: Found UCIP Comments: 10/08/2024 Record updated from Non-Urgent to No Action Needed. Removed code 12b since pipe is drainage and record source is Levee Log and O&M. Removed code 8 since pipe was inspected in 2021; only close-up inspection was not possible due to standing water and pipe appeared to operator as intended. (M. Thao - DWR UCIP) 2/20/2022 Record updated from Urgent to Non-Urgent. Pipe has been CIPP-lined. LOF of crossing is less or equal to 4. Recommend next video inspection in 5 years. (O.Yakimov - DWR UCIP) 6/23/2021 The record has been upgraded from Non-Urgent to Urgent. DWR DMP internal inspection has found pipe integrity issues. LOF of crossing is is greater than or equal to 5 and less than 6. Crossing will be monitored until funding becomes available to address the issues. Standing water on both WS outlet and LS inlet, limiting closeup inspection on both sides. Water appeared to be leaking through the WS flapgate, even though it was closed. No permit was found authorizing this encroachment. CVFPB will need to review crossing to determine owner. The UCIP inspection was completed with GEI staff, P. Espinoza. (H. Dunn ? GEI) 4/23/2014 Dense vegetation limits the inspector's visibility to identify signs of pipe failure (leaks) along the landward slope. Recommend removing vegetation along pipe alignment to conduct proper inspection of structure. (W. Wylie - DWR UCIP) FIELD_STRUCT_DESC: 24-inch CIPP-lined corrugated metal gravity drainage pipe (CMP) through the levee, 12.4 feet below the crown. Flap gate on the waterside (WS) end. Concrete headwall on the landside (LS) end. Concrete U-shaped headwall on the WS end. [Additional Reference(s): DWR Levee Log, 2002, (HLM 21.81). USACE San Joaquin O&M Manual, Unit No. 601, Part No. 1, 1967, Amended in 1978, Revised 20 June 1985, (HLM 21.81). DWR As-Built Specification No. 64-01, Sheet No. 5, 6 November 1963, (HLM 21.81)]. FS Date: 6/23/2021 10:27:38 AM

LS view: Closeup of pipe inlet and water at toe.

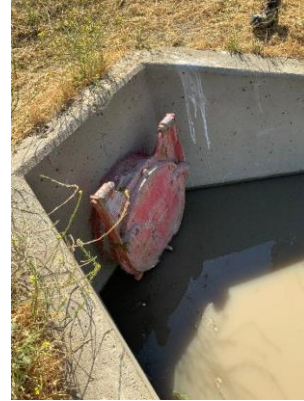
Photo 2 of 2 : UCIP_FA_2024_84977_104202.jpg

WS view: Closeup of flapgate and water at toe.

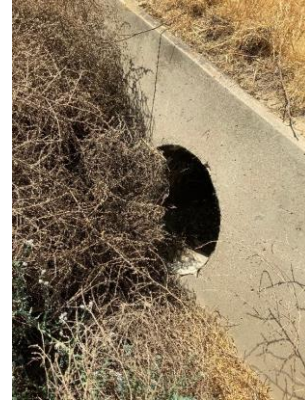
Photo 1 of 1 : UCIP_FA_2024_84969_104204.jpg

DS_ID:19788
FS_ID:84969
EP_NO: N/A
Repair Type: No Action Needed
EVAL Issue:
Crossing Status: Found
UCIP Comments: 10/07/2024 Record updated from Non-Urgent to No Action Needed. Removed code 12b since pipe is drainage and record source is Levee Log and O&M. Removed code 11 since vegetation is not maintenance of the pipe. (M. Thao - DWR UCIP 10/20/2022)
Record updated from Urgent to Non-Urgent. Pipe has been CIPP-lined. LOF of crossing is less or equal to 4. Recommend next video inspection in 5 years. (O. Yakimov - DWR UCIP 06/23/2021 The record has been upgraded from Non-Urgent to Urgent. DWR DMP internal inspection has found pipe integrity issues. LOF of crossing is greater than or equal to 5 and less than 6. Crossing will be monitored until funding becomes available to address the issues. Limited inspection of the LS pipe inlet due to dense tumbleweeds and vegetation, recommend removal. No permit was found authorizing this encroachment. CVFPB will need to review crossing to determine owner. The UCIP inspection was completed with GEI staff, P. Espinoza. (H. Dunn ? GEI 04/23/2014 Dense vegetation limits the inspector's visibility to identify signs of pipe failure (leaks) along the landward slope. Recommend removing vegetation along pipe alignment to conduct proper inspection of structure. (W. Wylie - DWR UCIP)

FIELD_STRUCT_DESC: 24-inch CIPP-lined corrugated metal gravity drainage pipe (CMP) through the levee, 10.7 feet below the crown. Flap gate on the waterside (WS) end. Concrete headwall on the landside (LS) end. Concrete U-shaped headwall on the WS end. [Additional Reference(s): DWR Levee Log, 2002, (HLM 21.85). USACE San Joaquin O&M Manual, Unit No. 601, Part No. 1, 1967, Amended in 1978, Revised 20 June 1985, (HLM 21.85). DWR As-Built Specification No. 64-01, Sheet No. 5, 6 November 1963, (HLM 21.85)].
FS Date: 6/23/2021 10:28:44 AM

LS view: Closeup of pipe inlet and vegetation at toe.

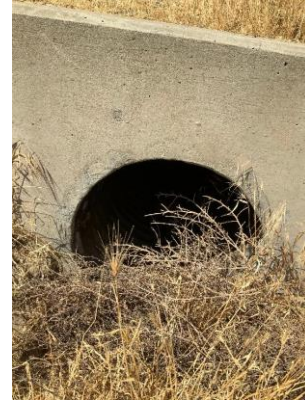
Photo 1 of 2 : UCIP_FA_2024_84944_104210.jpg

DS_ID:19789
FS_ID:84944
EP_NO: N/A
Repair Type: No Action Needed
EVAL Issue:
Crossing Status: Found
UCIP Comments: 10/07/2024 Record updated from Non-Urgent to No Action Needed. Removed code 12b since pipe is drainage and record source is Levee Log and O&M. Removed code 11 since vegetation is not maintenance of the pipe. (M. Thao - DWR UCIP)
12/20/2022 Record updated from Urgent to Non-Urgent. Pipe has been CIPP-lined. LOF of crossing is less or equal to 4. Recommend next video inspection in 5 years. (O.Yakimov - DWR UCIP)
06/23/2021 The record has been upgraded from Non-Urgent to Urgent. DWR DMP internal inspection has found pipe integrity issues. LOF of crossing is is greater than or equal to 5 and less than 6. Crossing will be monitored until funding becomes available to address the issues. Some vegetation growing over LS pipe inlet, recommend removal. No permit was found authorizing this encroachment. CVFPB will need to review crossing to determine owner. The UCIP inspection was completed with GEI staff, P. Espinoza. (H. Dunn ? GEI)

04/23/2014 Dense vegetation limits the inspector's visibility to identify signs of pipe failure (leaks) along the landward slope. Recommend removing vegetation along pipe alignment to conduct proper inspection of structure. Sediment buildup in pipe visible from landward side--recommend contacting owner to clear pipe. (W. Wylie - DWR UCIP)
FIELD_STRUCT_DESC: 24-inch CIPP-lined corrugated metal gravity drainage pipe (CMP) through the levee, 10.2 feet below the crown. Flap gate on the waterside (WS) end. Concrete headwall on the landside (LS) end. Concrete U-shaped headwall on the WS end. [Additional Reference(s): DWR Levee Log, 2002, (HLM 22.18). USACE San Joaquin O&M Manual, Unit No. 601, Part No. 1, 1967, Amended in 1978, Revised 20 June 1985, (HLM 22.19). DWR As-Built Specification No. 64-01, Sheet No. 5, 6 November 1963, (HLM 22.19)].
FS Date: 6/23/2021 10:29:25 AM

LS view: Closeup of inlet covered by vegetation at toe.

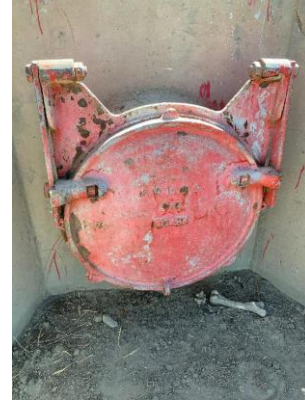
Photo 2 of 2 : UCIP_FA_2024_84944_104215.jpg

WS view: Closeup of flapgate at toe.

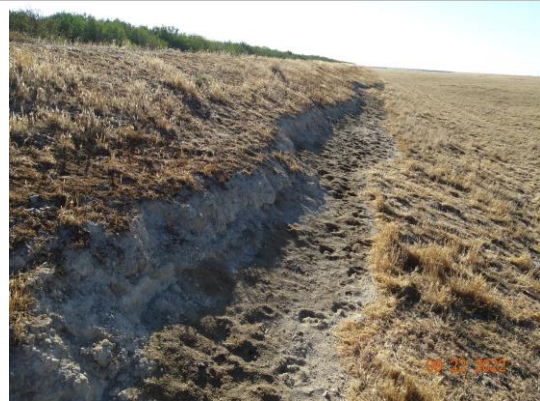
Photo 1 of 1 : FA_2024_NA0010_123_121_20240828_00018.jpg

LM Start	22.28	Rating **	M	Issue No.	121
LM End	22.35	Issue Type +	Ma	Location *	WS
Category	Earthen Levee			GPS Latitude/Longitude	
				Start	End
Item	Erosion / Livestock			37.083388 °	37.082696 °
				-120.528382 °	-120.527620 °
DWR ID	DWR_NA0010_05_f _ 2017_121				
Comment Code					
E4 : Repair the levee slope damaged by livestock and prevent large animal access.					
Inspector Comment					
Waterside slope damaged by animal traffic.

Looking southeast at the waterside slope. (Fall 2022)

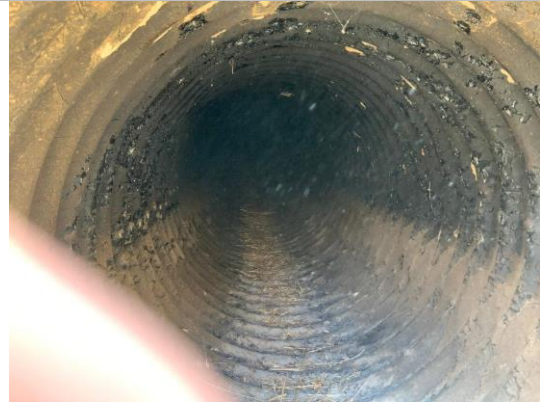
Photo 1 of 3 : UCIP_FA_2024_84945_104218.jpg

Comment Code						
Inspector Comment						
DS_ID:19790 FS_ID:84945 EP_NO: N/A Repair Type: No Action Needed EVAL Issue: Crossing Status: Found UCIP Comments: 10/07/2024 Record updated from Non-Urgent to No Action Needed. Removed code 12b since pipe is drainage and record source is Levee Log and O&M. (M. Thao - DWR UCIP)2/20/2022 Record updated from Urgent to Non-Urgent. Pipe has been CIPP-lined. LOF of crossing is less or equal to 4. Recommend next video inspection in 5 years. (O.Yakimov - DWR UCIP)6/23/2021 The record has been upgraded from Non-Urgent to Urgent. DWR DMP internal inspection has found pipe integrity issues. LOF of crossing is greater than or equal to 5 and less than 6. Crossing will be monitored until funding becomes available to address the issues. Possible hole in WS flapgate. No permit was found authorizing this encroachment. CVFPB will need to review crossing to determine owner. The UCIP inspection was completed with GEI staff, P. Espinoza. (H. Dunn ? GEI)4/23/2014 Dense vegetation limits the inspector's visibility to identify signs of pipe failure (leaks) along the landward slope. Recommend removing vegetation along pipe alignment to conduct proper inspection of structure. Sediment buildup in pipe visible from landward side--recommend contacting owner to clear pipe. (W. Wylie - DWR UCIP) FIELD_STRUCT_DESC: 24-inch CIPP-lined corrugated metal gravity drainage pipe (CMP) through the levee, 10.4 feet below the crown. Flap gate on the waterside (WS) end. Concrete headwall on the landside (LS) end. Concrete U-shaped headwall on the WS end. [Additional Reference(s): DWR Levee Log, 2002, (HLM 22.46). USACE San Joaquin O&M Manual, Unit No. 601, Part No. 1, 1967, Amended in 1978, Revised 20 June 1985, (HLM 22.46). DWR As-Built Specification No. 64-01, Sheet No. 6, 6 November 1963, (HLM 22.46)]. FS Date: 6/23/2021 10:30:24 AM

LS view: Inside pipe inlet at toe.

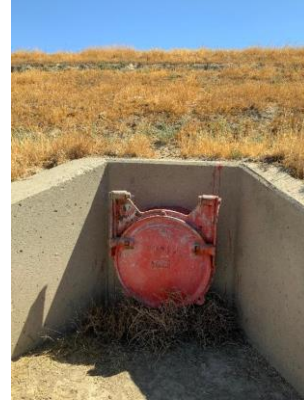
Photo 2 of 3 : UCIP_FA_2024_84945_104222.jpg

WS view: Slope, headwall, and flapgate from toe.

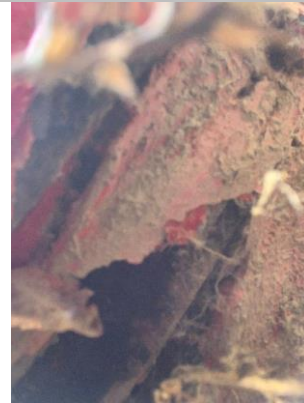
Photo 3 of 3 : UCIP_FA_2024_84945_104223.jpg

WS view: Closeup of hole in flapgate at toe.

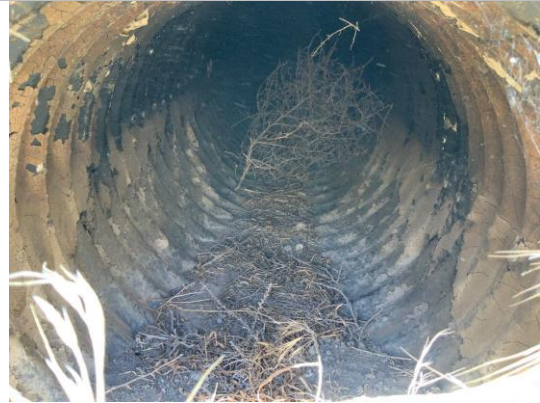
Photo 1 of 3 : UCIP_FA_2024_84946_104228.jpg

DS_ID:19791
FS_ID:84946
EP_NO: N/A
Repair Type: No Action Needed
EVAL Issue:
Crossing Status: Found
UCIP Comments: 10/07/2024 Record updated from Non-Urgent to No Action Needed. Removed code 12b since pipe is drainage and record source is Levee Log and O&M. (M. Thao - DWR UCIP) 12/20/2022 Record updated from Urgent to Non-Urgent. Pipe has been CIPP-lined. LOF of crossing is less or equal to 4. Recommend next video inspection in 5 years. (O.Yakimov - DWR UCIP)
06/23/2021 The record has been upgraded from Non-Urgent to Urgent. DWR DMP internal inspection has found pipe integrity issues. LOF of crossing is greater than or equal to 5 and less than 6. Crossing will be monitored until funding becomes available to address the issues. Deterioration of the underside of the WS flapgate. No permit was found authorizing this encroachment. CVFPB will need to review crossing to determine owner. The UCIP inspection was completed with GEI staff, P. Espinoza. (H. Dunn ? GEI) 04/23/2014 Dense vegetation limits the inspector's visibility to identify signs of pipe failure (leaks) along the landward slope. Recommend removing vegetation along pipe alignment to conduct proper inspection of structure. Sediment buildup in pipe visible from landward side--recommend contacting owner to clear pipe. (W. Wylie - DWR UCIP)

FIELD_STRUCT_DESC: 24-inch CIPP-lined corrugated metal gravity drainage pipe (CMP) through the levee, 12.2 feet below the crown. Flap gate on the waterside (WS) end. Concrete headwall on the landside (LS) end. Concrete U-shaped headwall on the WS end. [Additional Reference(s): DWR Levee Log, 2002, (HLM 22.79). USACE San Joaquin O&M Manual, Unit No. 601, Part No. 1, 1967, Amended in 1978, Revised 20 June 1985, (HLM 22.79). DWR As-Built Specification No. 64-01, Sheet No. 6, 6 November 1963, (HLM 22.79)].
FS Date: 6/23/2021 10:31:02 AM

LS view: Inside pipe inlet at toe.

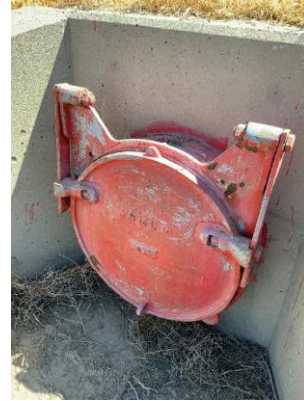
Photo 2 of 3 : UCIP_FA_2024_84946_104224.jpg

WS view: Closeup of flapgate at toe.

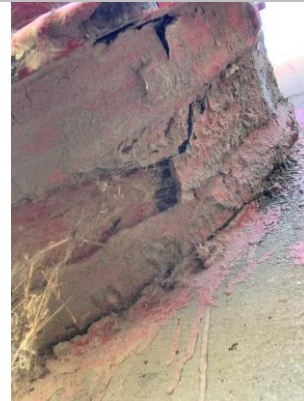
Photo 3 of 3 : UCIP_FA_2024_84946_104225.jpg

WS view: Deterioration and holes underneath flapgate at toe.

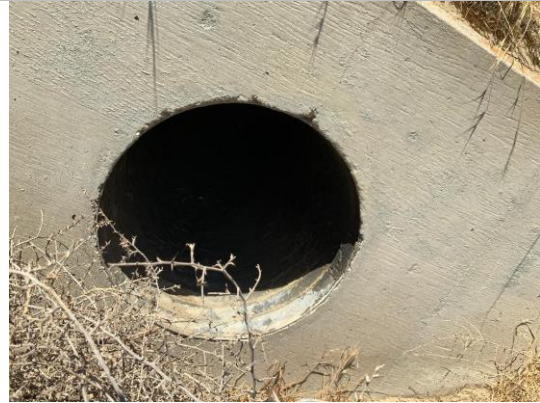
Photo 1 of 3 : UCIP_FA_2024_84947_104234.jpg

LS view: Closeup of pipe inlet at toe.

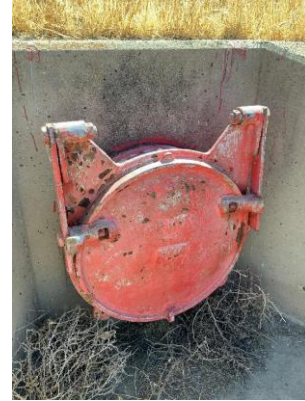
Photo 2 of 3 : UCIP_FA_2024_84947_104239.jpg

WS view: Closeup of flapgate at toe.

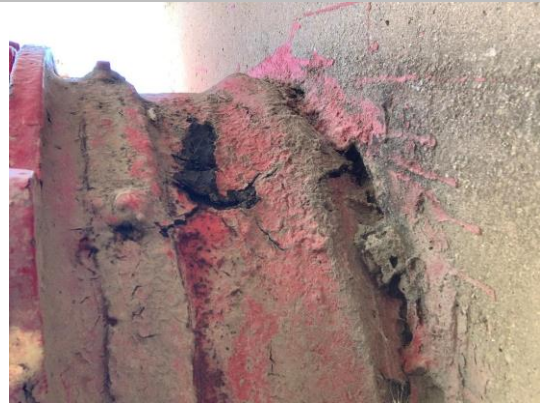
Photo 3 of 3 : UCIP_FA_2024_84947_104232.jpg

WS view: Some deterioration of flapgate at toe.

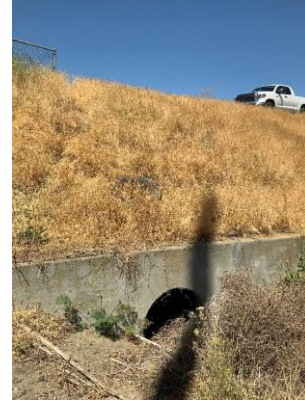
Photo 1 of 2 : UCIP_FA_2024_71053_104333.jpg

LS view: Slope and headwall from toe.

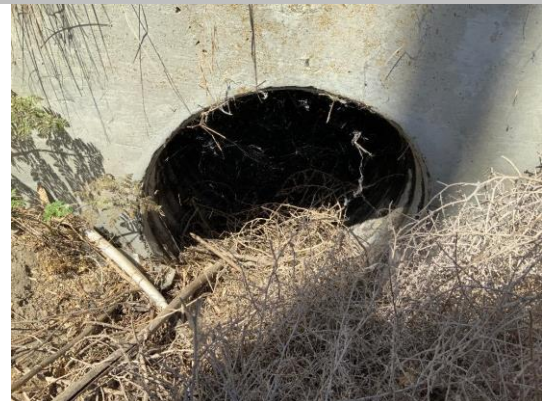
Photo 2 of 2 : UCIP_FA_2024_71053_104334.jpg

LS view: Closeup of inlet at toe.

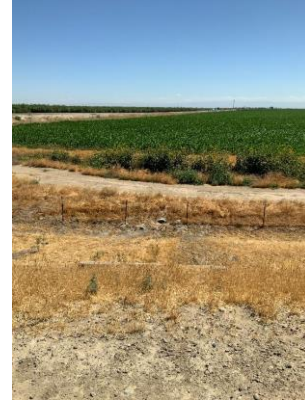
Photo 2 of 3 : UCIP_FA_2024_84948_104343.jpg

LS view: Toe from crown.

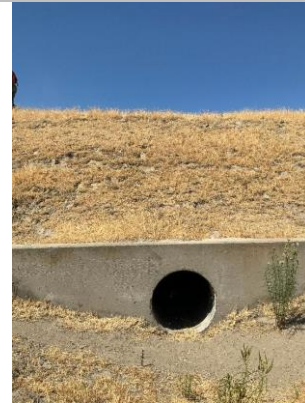
Photo 3 of 3 : UCIP_FA_2024_84948_104345.jpg

LS view: Slope and headwall from toe.

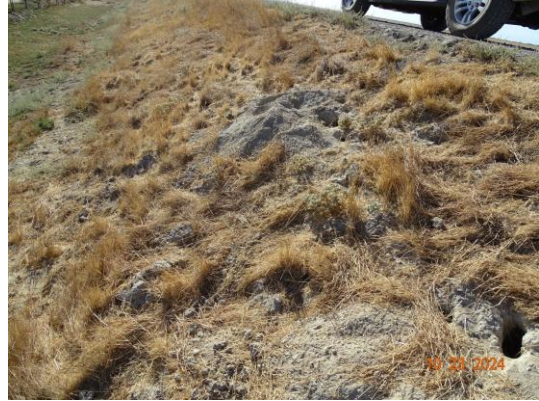
Photo 1 of 1 : FA_2024_NA0010_123_109_20241105_00293.jpg

LM Start	23.60	Rating **	M	Issue No.	109
LM End	23.60	Issue Type +	Ma	Location *	LS
Category	Earthen Levee			GPS Latitude/Longitude	
				Start	End
Item	Animal Control			37.069127°	37.069127°
				-120.512487°	-120.512487°
DWR ID	DWR_NA0010_05_f_2024_109				
Comment Code					
A3 : No rodents visible, but rodent burrows visible; need to backfill and compact or grout burrows.					
Inspector Comment

View of rodent burrows on the landside slope. (Fall 2024)

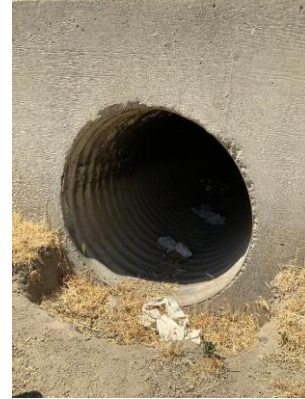
Photo 1 of 2 : UCIP_FA_2024_84949_104378.jpg

LS view: Closeup of pipe inlet at toe.

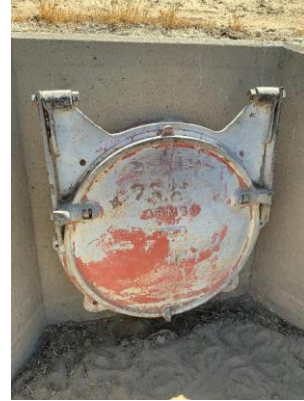
Photo 2 of 2 : UCIP_FA_2024_84949_104383.jpg

WS view: Closeup of flapgate at toe.

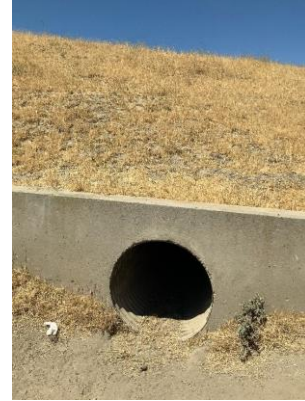
Photo 1 of 3 : UCIP_FA_2024_84950_104384.jpg

LS view: Slope and headwall from toe.

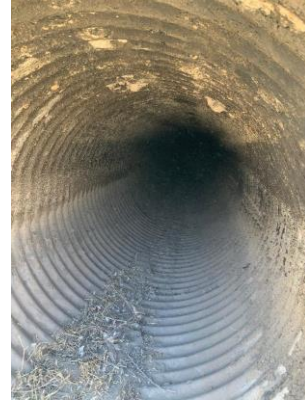
Photo 2 of 3 : UCIP_FA_2024_84950_104385.jpg

LS view: Closeup of inside inlet at toe.

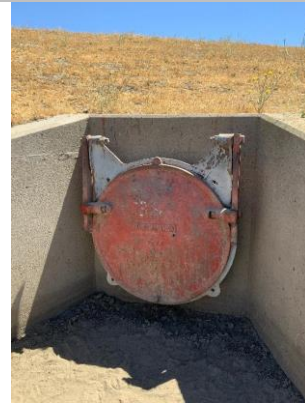
Photo 3 of 3 : UCIP_FA_2024_84950_104390.jpg

WS view: Closeup of flapgate at toe.

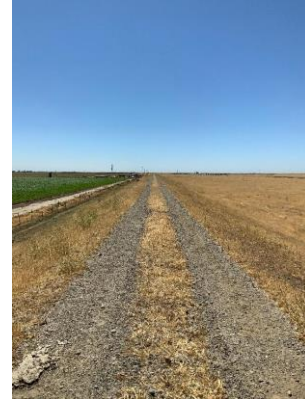
Photo 1 of 3 : UCIP_FA_2024_84951_104393.jpg

Levee crown.

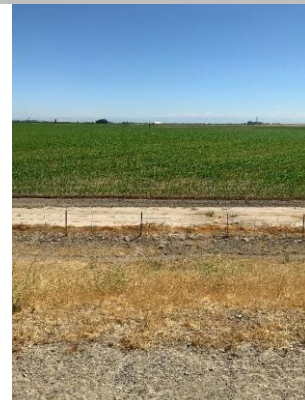
Photo 2 of 3 : UCIP_FA_2024_84951_104395.jpg

LS view: Toe from crown.

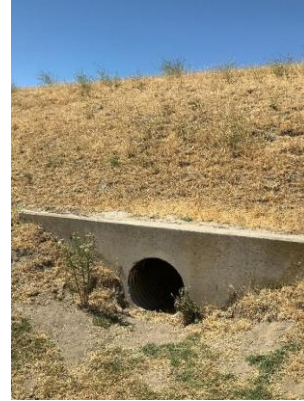
Photo 3 of 3 : UCIP_FA_2024_84951_104391.jpg

LS view: Slope and headwall from toe.

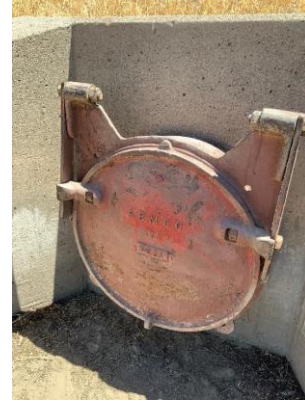
Photo 1 of 3 : UCIP_FA_2024_84952_104406.jpg

WS view: Closeup of flapgate at toe.

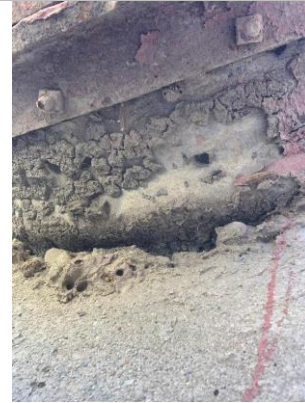
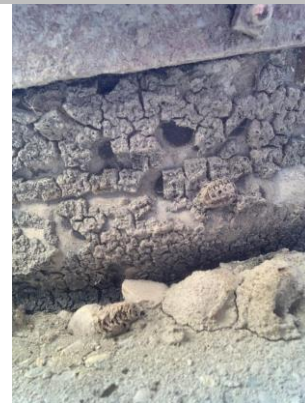
WS view: Closeup of hole under flapgate at toe, 1 of 2 photos.

WS view: Closeup of hole under flapgate at toe, 2 of 2 photos.

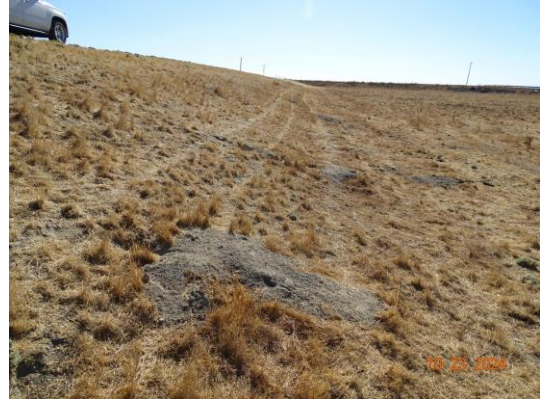
Photo 1 of 1 : FA_2024_NA0010_123_188_20241105_00294.jpg

LM Start	24.79	Rating **	M	Issue No.	188
LM End	24.79	Issue Type +	Ma	Location *	WS
Category	Earthen Levee			GPS Latitude/Longitude	
				Start	End
Item	Animal Control			37.056122°	37.056122°
				-120.498432°	-120.498432°
DWR ID	DWR_NA0010_05_f_2022_188				
Comment Code					
A3 : No rodents visible, but rodent burrows visible; need to backfill and compact or grout burrows.					
Inspector Comment					
Multiple burrows observed on the waterside slope and toe.

Several rodent burrows observed on the waterside slope. (Fall 2024)

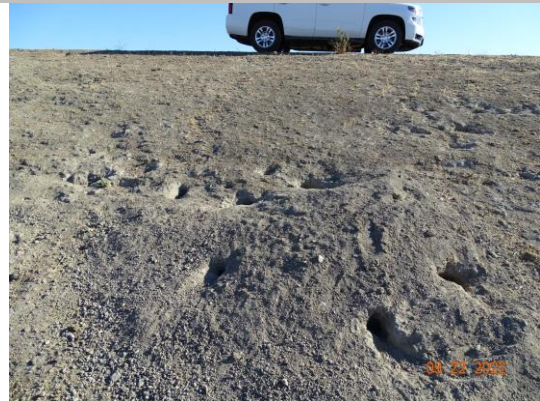
Photo 1 of 1 : FA_2024_NA0010_123_190_20240828_00060.jpg

LM Start	24.84	Rating **	M	Issue No.	190
LM End	24.84	Issue Type +	Ma	Location *	WS
Category	Earthen Levee			GPS Latitude/Longitude	
				Start	End
Item	Animal Control			37.055582 °	37.055582 °
				-120.497759 °	-120.497759 °
DWR ID	DWR_NA0010_05_f_2022_190				
Comment Code					
A3 : No rodents visible, but rodent burrows visible; need to backfill and compact or grout burrows.					
Inspector Comment

View of multiple rodent holes on the waterside slope. (Fall 2022)

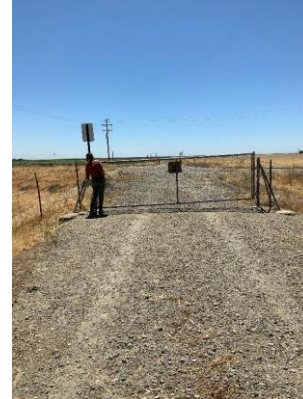
Photo 1 of 3 : UCIP_FA_2024_84953_104409.jpg

Levee crown.

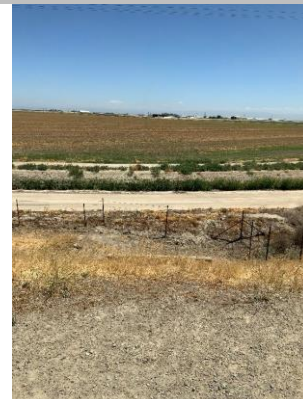
Photo 2 of 3 : UCIP_FA_2024_84953_104411.jpg

LS view: Toe from crown.

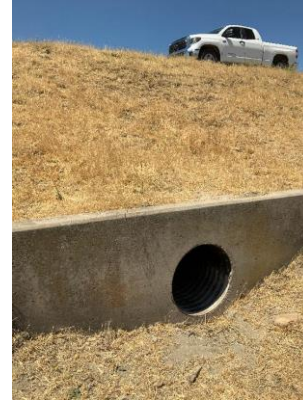
Photo 3 of 3 : UCIP_FA_2024_84953_104407.jpg

LS view: Slope and headwall from toe.

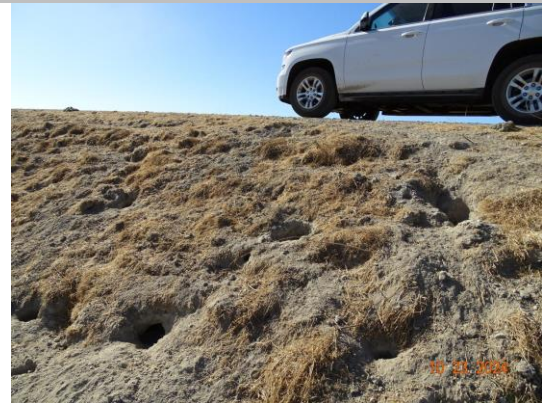
Photo 1 of 1 : FA_2024_NA0010_123_123_20241105_00295.jpg

LM Start	25.07	Rating **	U	Issue No.	123
LM End	25.07	Issue Type +	Ma	Location *	LS
Category	Earthen Levee			GPS Latitude/Longitude	
				Start	End
Item	Animal Control			37.053267 °	37.053267 °
				-120.494852 °	-120.494852 °
DWR ID	DWR_NA0010_05_f_2017_123				
Comment Code					
A1 : Exterminate rodents and backfill and compact or grout burrows.					
Inspector Comment

View of the landside slope looking upstream. (Fall 2024)

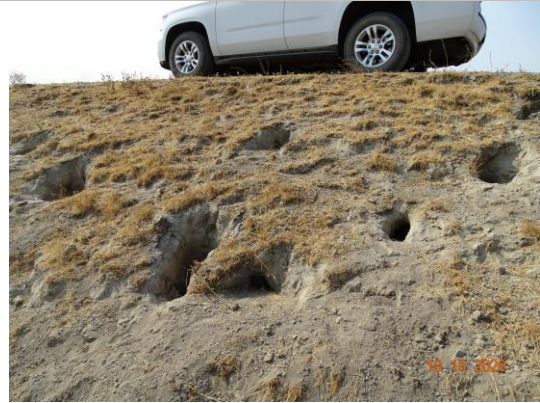
Photo 1 of 1 : FA_2024_NA0010_123_148_20240828_00033.jpg

LM Start	25.58	Rating **	U	Issue No.	148
LM End	25.60	Issue Type +	Ma	Location *	LS
Category	Earthen Levee			GPS Latitude/Longitude	
				Start	End
Item	Animal Control			37.047827 °	37.047551 °
				-120.488738 °	-120.488527 °
DWR ID	DWR_NA0010_05_f_2020_148				
Comment Code					
A3 : No rodents visible, but rodent burrows visible; need to backfill and compact or grout burrows.					
Inspector Comment

View of burrows in the landside. (Fall 2020)

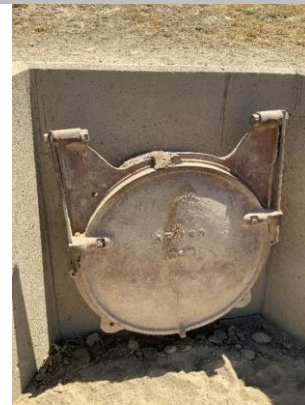
Photo 3 of 3 : UCIP_FA_2024_84956_104435.jpg

WS view: Closeup of flapgate at toe.

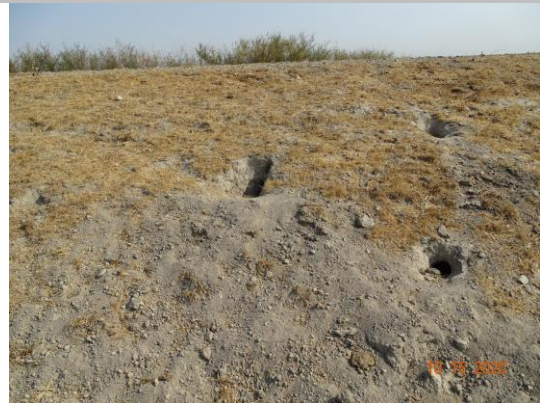
Photo 1 of 1 : FA_2024_NA0010_123_124_20240828_00020.jpg

LM Start	25.61	Rating **	M	Issue No.	124
LM End	25.61	Issue Type +	Ma	Location *	WS
Category	Earthen Levee			GPS Latitude/Longitude	
				Start	End
Item	Animal Control			37.047416 °	37.047416 °
				-120.488411 °	-120.488411 °
DWR ID	DWR_NA0010_05_f_2017_124				
Comment Code					
A1 : Exterminate rodents and backfill and compact or grout burrows.					
Inspector Comment

Looking east at the waterside slope. (Fall 2020)

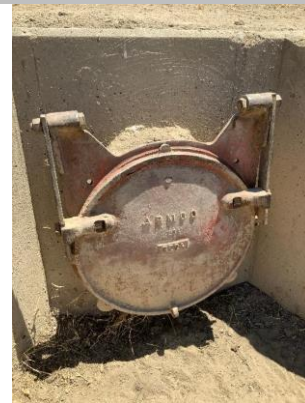
Photo 3 of 3 : UCIP_FA_2024_84958_104454.jpg

WS view: Closeup of flapgate at toe.

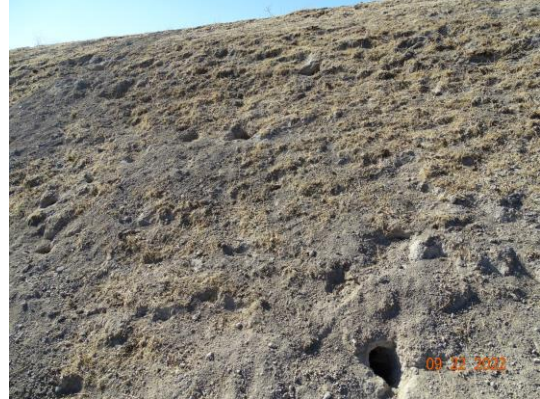
Photo 1 of 1 : FA_2024_NA0010_123_191_20240828_00061.jpg

LM Start	26.85	Rating **	M	Issue No.	191
LM End	26.92	Issue Type +	Ma	Location *	LS
Category	Earthen Levee			GPS Latitude/Longitude	
				Start	End
Item	Animal Control			37.032891 °	37.032685 °
				-120.475608 °	-120.474378 °
DWR ID	DWR_NA0010_05_f _ 2022_191				
Comment Code					
A3 : No rodents visible, but rodent burrows visible; need to backfill and compact or grout burrows.					
Inspector Comment

View of rodent burrows in the landside slope. (Fall 2022)

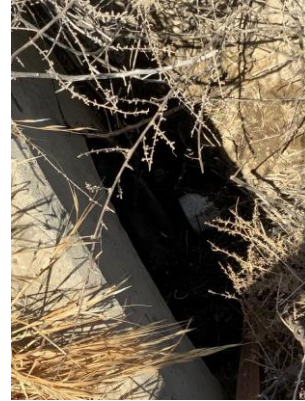
Photo 2 of 2 : UCIP_FA_2024_84961_104362.jpg

Comment Code						
Inspector Comment						
DS_ID:19748 FS_ID:84961 EP_NO: N/A Repair Type: Non-Urgent EVAL Issue: Crossing Status: Found UCIP Comments: 12/20/2022 Record updated from Urgent to Non-Urgent. Pipe has been CIPP-lined. LOF of crossing is less or equal to 4. Recommend next video inspection in 5 years. (O.Yakimov - DWR UCIP) 06/23/2021 Record has been upgraded from Non-Urgent to Urgent. DWR DMP internal inspection has found pipe integrity issues. LOF of crossing is greater than or equal to 5 and less than 6. Crossing will be monitored until funding becomes available to address the issues. Limited inspection of LS inlet due to dirt and tumbleweeds, recommend removal. Unidentified PVC pipe installed at mouth of inlet pipe on LS. No permit was found authorizing this encroachment. CVFPB will need to review crossing to determine owner. The UCIP inspection was completed with GEI staff, H.Dunn. (P.Espinoza ? GE03/25/2014 Tumble weed buildup at inlet mat create blockage and should be removed. (W. Wylie - DWR UCIP) FIELD_STRUCT_DESC: 24-inch CIPP-lined corrugated metal gravity drainage pipe (CMP) through the levee, 11.3 feet below the crown. Flap gate on the waterside (WS) end. Concrete headwall on the landside (LS) end. Concrete U-shaped headwall on the WS end. [Additional Reference(s): DWR Levee Log, 2002, (HLM 26.87). USACE San Joaquin O&M Manual, Unit No. 601, Part No. 1, 1967, Amended in 1978, Revised 20 June 1985, (HLM 26.87). DWR As-Built Specification No. 64-01, Sheet No. 9, 6 November 1963, (HLM 26.87)]. FS Date: 6/23/2021 9:44:25 AM

LS view from toe: close up of inlet. PVC pipe at entrance.

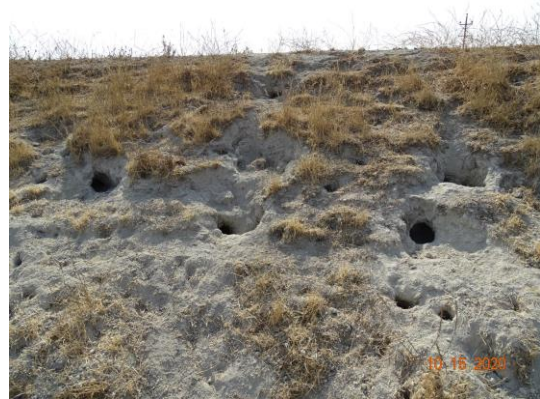
Photo 1 of 1 : FA_2024_NA0010_123_162_20240828_00041.jpg

LM Start	26.99	Rating **	U	Issue No.	162
LM End	27.04	Issue Type +	Ma	Location *	LS
Category	Earthen Levee			GPS Latitude/Longitude	
				Start	End
Item	Animal Control			37.032651 °	37.032659 °
				-120.473205 °	-120.472190 °
DWR ID	DWR_NA0010_05_f_2018_162				
Comment Code					
A1 : Exterminate rodents and backfill and compact or grout burrows.					
Inspector Comment					
Several rodent burrows with large quantities of material displaced noted in this section.

Several rodent burrows noted in this section of the levee. (Fall 2020)
