Flood Control Project Maintenance Levee Inspections

Fall 2024 Levee Maintenance Deficiency Summary Report

San Joaquin River Basin

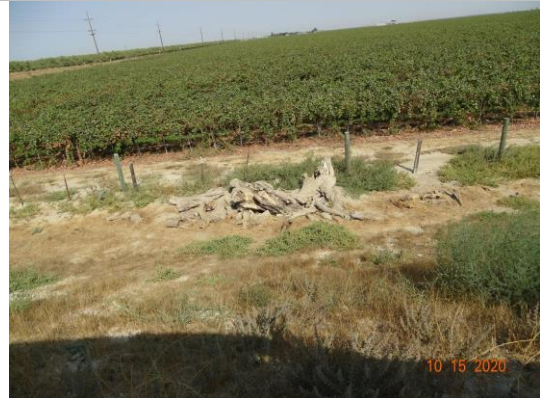
Photo 1 of 1 : FA_2024_NA0010_123_125_20240828_00021.jpg

LM Start	27.01	Rating **	A/W	Issue No.	125
LM End	27.01	Issue Type +	Ma	Location *	LS
Category	Earthen Levee			GPS Latitude/Longitude	
				Start	End
Item	Trim / Thin Trees			37.032675 °	37.032675 °
				-120.472841 °	-120.472841 °
DWR ID	DWR_NA0010_05_s_2021_125				
Comment Code					
T2 : Tree or limb.					
Inspector Comment

Prunings left on the landside toe. (Fall 2020)

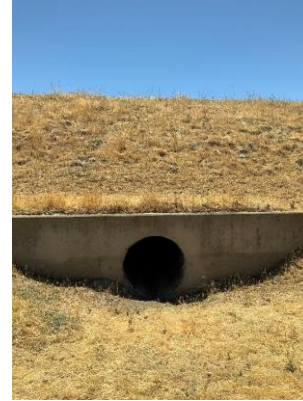
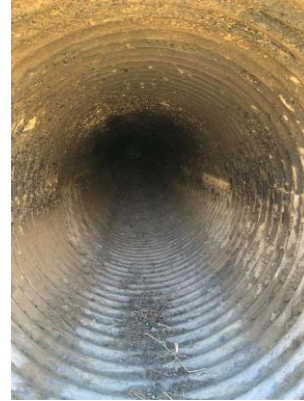
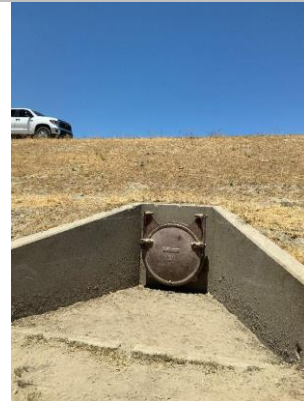
Comment Code						
Inspector Comment						
DS_ID:19749 FS_ID:84962 EP_NO: N/A Repair Type: No Action Needed EVAL Issue: Crossing Status: Found UCIP Comments: 10/07/2024 Record updated from Non-Urgent to No Action Needed. Removed code 12b since pipe is drainage and record source is Levee Log and O&M. (M. Thao - DWR UCIP 2/20/2022 Record updated from Urgent to Non-Urgent. Pipe has been CIPP-lined. LOF of crossing is less or equal to 4. Recommend next video inspection in 5 years. (O. Yakimov - DWR UCIP) 06/23/2021 The record has been upgraded from No Action Needed to Urgent. DWR DMP internal inspection has found pipe integrity issues. LOF of crossing is greater than or equal to 5 and less than 6. Crossing will be monitored until funding becomes available to address the issues. No permit was found authorizing this encroachment. CVFPB will need to review crossing to determine owner. The UCIP inspection was completed with GEI staff, H.Dunn. (P.Espinoza ? GEI) FIELD_STRUCT_DESC: 36-inch CIPP-lined corrugated metal gravity drainage pipe (CMP) through the levee, 12.0 feet below the crown. Flap gate on the waterside (WS) end. Concrete headwall on the landside (LS) end. Concrete U-shaped headwall on the WS end. [Additional Reference(s): DWR Levee Log, 2002, (HLM 27.21). USACE San Joaquin O&M Manual, Unit No. 601, Part No. 1, 1967, Amended in 1978, Revised 20 June 1985, (HLM 27.22). DWR As-Built Specification No. 64-01, Sheet No. 10, 6 November 1963, (HLM 27.22)]. FS Date: 6/23/2021 9:46:35 AM

LS view from toe: concrete headwall at inlet.

LS view from toe: inside of inlet.

WS view from toe: flapgate on concrete headwall at outlet.

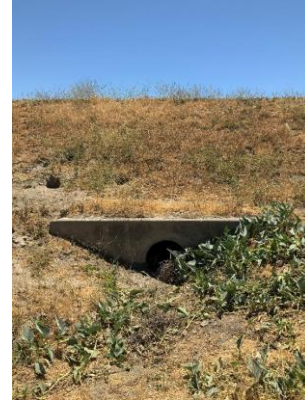
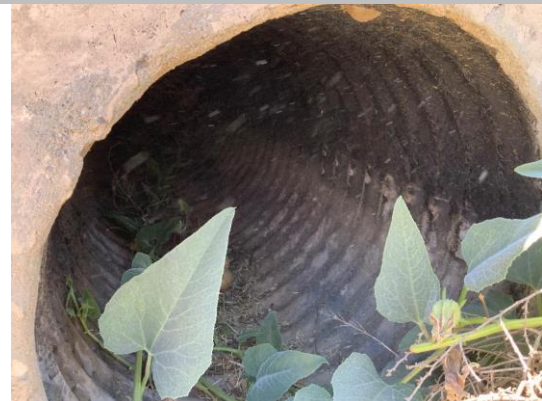
Comment Code						
Inspector Comment						
DS_ID:19750 FS_ID:84963 EP_NO: N/A Repair Type: Non-Urgent EVAL Issue: 11, Maintenance Compliance Issue Crossing Status: Found UCIP Comments: 06/23/2021 The record remains Non-Urgent. DWR DMP internal inspection has not found pipe integrity issues. LOF of crossing is less or equal to 4.0. Recommend next video inspection in 5 years. Sediment buildup in inlet pipe; recommend removal. No permit was found authorizing this encroachment. CVFPB will need to review crossing to determine owner. The UCIP inspection was completed with GEI staff, P. Espinoza. (H. Dunn ? GEI)03/25/2014 Animal Burrowing activity at LS toe may undermine headwall. (W. Wylie - DWR UCIP) FIELD_STRUCT_DESC: 24-inch corrugated metal gravity drainage pipe (CMP) through the levee, 10.8 feet below the crown. Flap gate on the waterside (WS) end. Concrete headwall on the landside (LS) end. Concrete U-shaped headwall on the WS end. [Additional Reference(s): DWR Levee Log, 2002, (HLM 28.17). USACE San Joaquin O&M Manual, Unit No. 601, Part No. 1, 1967, Amended in 1978, Revised 20 June 1985, (HLM 28.17). DWR As-Built Specification No. 64-01, Sheet No. 10, 6 November 1963, (HLM 28.17)]. FS Date: 6/23/2021

LS view from toe: concrete headwall at inlet.

LS view from toe: inside of inlet pipe.

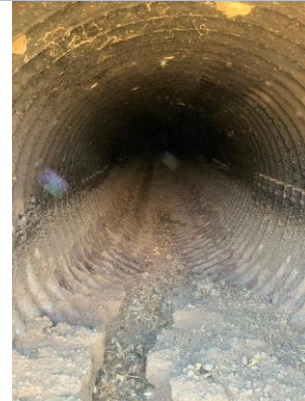
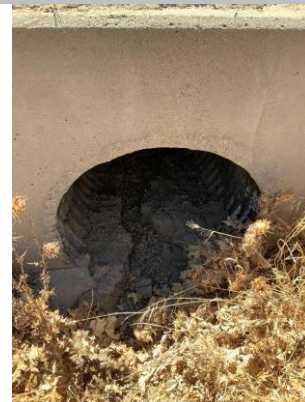
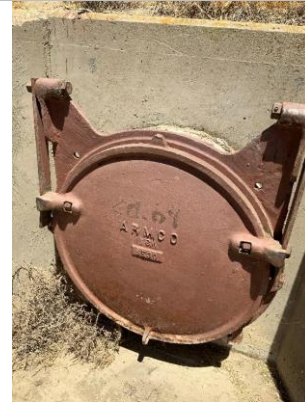
DS_ID:19751
FS_ID:84964
EP_NO: N/A
Repair Type: Non-Urgent
EVAL Issue: 11, Maintenance Compliance Issue
Crossing Status: Found
UCIP Comments: 12/20/2022 Record updated from Urgent to Non-Urgent. Pipe has been CIPP-lined. LOF of crossing is less or equal to 4. Recommend next video inspection in 5 years. (O.Yakimov - DWR UCIP)
06/23/2021 The record has been upgraded from No Action Needed to Urgent. DWR DMP internal inspection has found pipe integrity issues. LOF of crossing is between 5 and 6. Crossing will be monitored until funding becomes available to address the issues. Sediment build up in LS pipe inlet; recommend removal. No permit was found authorizing this encroachment. CVFPB will need to review crossing to determine owner. The UCIP inspection was completed with GEI staff, H.Dunn. (P.Espinoza ? GEI)
FIELD_STRUCT_DESC: 30-inch CIPP-lined corrugated metal gravity drainage pipe (CMP) through the levee, 9.8 feet below the crown. Flap gate on the waterside (WS) end. Concrete headwall on the landside (LS) end. Concrete U-shaped headwall on the WS end. [Additional Reference(s): DWR Levee Log, 2002, (HLM 28.69). USACE San Joaquin O&M Manual, Unit No. 601, Part No. 1, 1967, Amended in 1978, Revised 20 June 1985, (HLM 28.69). DWR As-Built Specification No. 64-01, Sheet No. 11, 6 November 1963, (HLM 28.69)].

LS view: inside of pipe.

LS view from toe: closeup of entrance to pipe.

WS view from toe: closeup of flapgate.

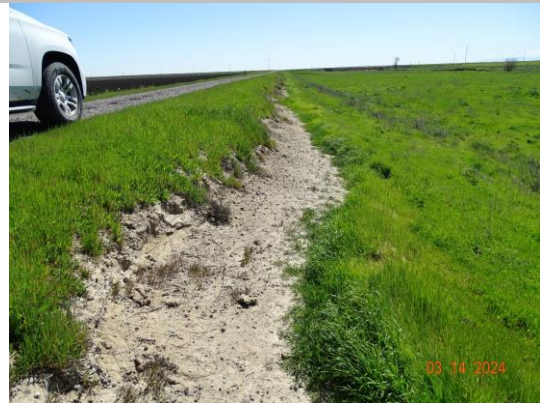
Photo 1 of 1 : FA_2024_NA0010_123_164_20240828_00042.jpg

LM Start	29.43	Rating **	M	Issue No.	164
LM End	29.56	Issue Type +	Ma	Location *	WS
Category	Earthen Levee			GPS Latitude/Longitude	
				Start	End
Item	Erosion / Livestock			37.023481 °	37.021794 °
				-120.435960 °	-120.434769 °
DWR ID	DWR_NA0010_05_f _ 2018_164				
Comment Code					
E4 : Repair the levee slope damaged by livestock and prevent large animal access.					
Inspector Comment					
There is slope damage on waterside from livestock traffic.

Looking upstream along the waterside slope.

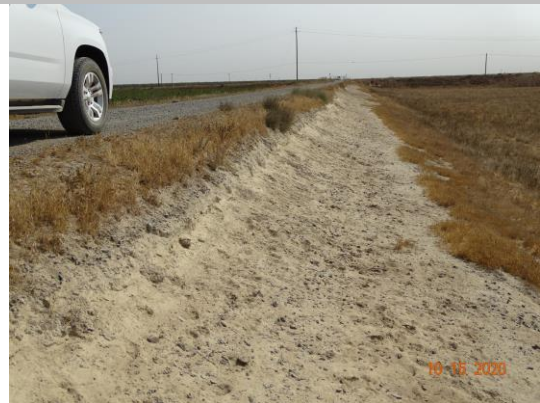
Photo 1 of 1 : FA_2024_NA0010_123_171_20240828_00047.jpg

LM Start	29.58	Rating **	U	Issue No.	171
LM End	29.80	Issue Type +	Ma	Location *	WS
Category	Earthen Levee			GPS Latitude/Longitude	
				Start	End
Item	Erosion / Livestock			37.021534 °	37.018712 °
				-120.434592 °	-120.432682 °
DWR ID	DWR_NA0010_05_s_2014_171				
Comment Code					
E4 : Repair the levee slope damaged by livestock and prevent large animal access.					
Inspector Comment					
There is waterside erosion caused by livestock.

Looking south at livestock erosion on the waterside slope. (Fall 2020)

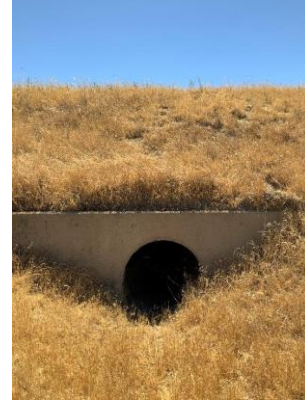
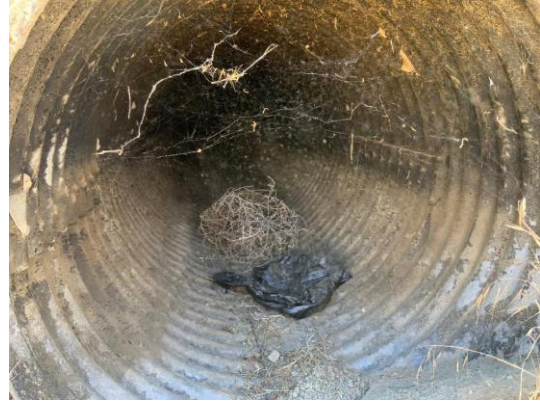
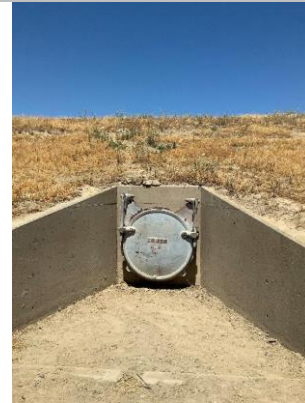
Comment Code						
Inspector Comment						
<p>DS_ID:19753 FS_ID:71076 EP_NO: N/A Repair Type: No Action Needed EVAL Issue: Crossing Status: Found UCIP Comments: 09/18/2023 Record updated from Non-Urgent to No Action Needed. Pipe was CIPP lined. DMP internal video inspection has found none or minor pipe defects. Recommend next video inspection in 5 years. (O. Yakimov - DWR UCIP) 06/23/2021 The record remains Non-Urgent. DWR DMP internal inspection has found pipe integrity issues. LOF of crossing is between 4.1 and 5. Crossing will be monitored until funding becomes available for rehabilitation. No permit was found authorizing this encroachment. CVFPB will need to review crossing to determine owner. The UCIP inspection was completed with GEI staff, H.Dunn. (P.Espinoza ? GEI) 03/27/2014 Dense vegetation limits the inspector's visibility to identify signs of pipe failure (leaks) along the landward slope. Recommend removing vegetation along pipe alignment to conduct proper inspection of structure. Sediment buildup in pipe visible from landward side--recommend contacting owner to clear pipe. (W. Wylie - DWR UCIP) FIELD_STRUCT_DESC: 36-inch CIPP-lined corrugated metal gravity drainage pipe (CMP) through the levee, 10.2 feet below the crown. Flap gate on the waterside (WS) end. Concrete headwall on the landside (LS) end. Concrete U-shaped headwall on the WS end. [Additional Reference(s): DWR Levee Log, 2002, (HLM 29.49). USACE San Joaquin O&M Manual, Unit No. 601, Part No. 1, 1967, Amended in 1978, Revised 20 June 1985, (HLM 29.49). DWR As-Built Specification No. 64-01, Sheet No. 12, 6 November 1963, (HLM 29.49)]. FS Date: 6/23/2021</p>

LS view from toe: concrete headwall at inlet.

LS view from toe: inside of inlet pipe.

WS view from toe: flapgate on concrete headwall at outlet.

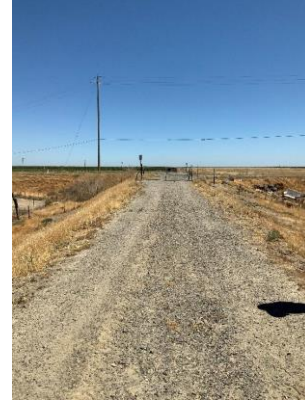
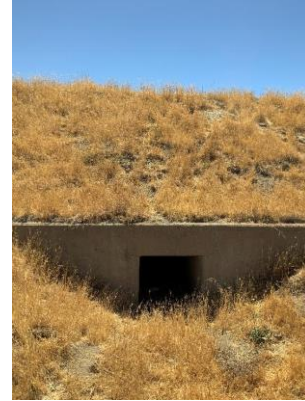
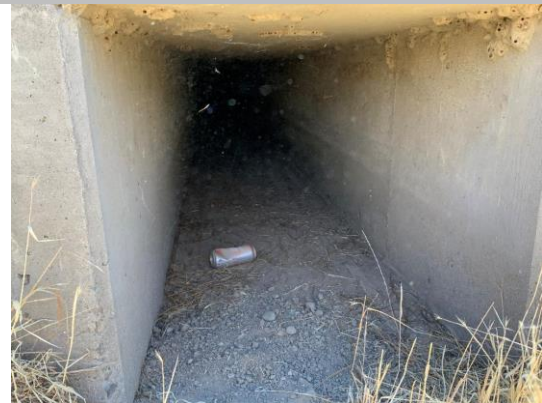
Comment Code					
Inspector Comment					
DS_ID:19754 FS_ID:85074 EP_NO: N/A Repair Type: Non-Urgent EVAL Issue: 5, Pipe Damage Crossing Status: Found UCIP Comments: 10/21/2024 Record updated from Urgent to Non-Urgent. LoF rating was changed due to the difference in CCTV operator opinion of if visible reinforcement is corroded (Grade 5) or not (Grade 4). (O. Yakimov - DWR UCIP) 12/14/2022 Record updated from Non-Urgent to Urgent. DMP internal video inspection has found severe pipe defects. Crossing will be monitored until funding becomes available to address the issues. (O.Yakimov - DWR UCIP) 06/23/2021 The record remains Non-Urgent. Crossing appears to be in good condition. No permit was found authorizing this encroachment. CVFPB will need to review crossing to determine owner. The UCIP inspection was completed with GEI staff, H.Dunn. (P.Espinoza ? GEI) 03/27/2014 Dense vegetation limits the inspector's visibility to identify signs of pipe failure (leaks) along the landward slope. Recommend removing vegetation along pipe alignment to conduct proper inspection of structure. (W. Wylie - DWR UCIP) FIELD_STRUCT_DESC: 30-inch by 30-inch reinforced concrete box gravity drainage culvert (RCBC) through the levee, 12.0 feet below the crown. Flap gate on the waterside (WS) end. Concrete headwall on the landside (LS) end. Concrete U-shaped headwall on the WS end. [Additional Reference(s): DWR Levee Log, 2002, (HLM 29.72). USACE San Joaquin O&M Manual, Unit No. 601, Part No. 1, 1967, Amended in 1978, Revised 20 June 1985, (HLM 29.72). DWR As-Built Specification No. 64-42, Sheet No. 6, 13 August 1964, (HLM 29.72)]. FS Date: 6/23/2021 1:52:38 PM

View from levee crown.

LS view from toe: concrete headwall at inlet.

LS view from toe: inside of inlet.

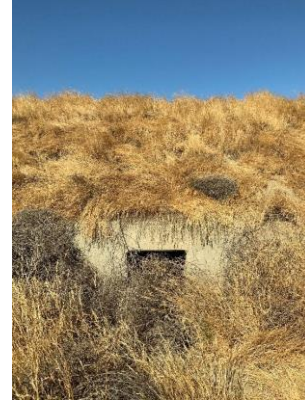
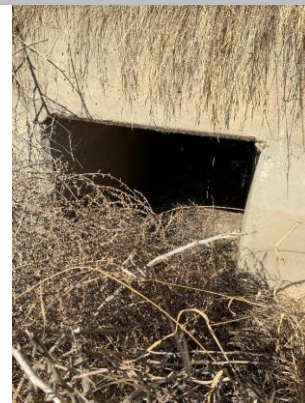
Comment Code						
Inspector Comment						
DS_ID:19696 FS_ID:71078 EP_NO: N/A Repair Type: Non-Urgent EVAL Issue: 5, Pipe Damage Crossing Status: Found UCIP Comments: 09/25/2024 DMP internal video inspection has found moderate pipe defects. Crossing will be monitored until funding becomes available for rehabilitation. (O. Yakimov - DWR UCIP) 06/24/2021 The record remains Non-Urgent. Limited inspection of LS due to dense vegetation; recommend removal. No permit was found authorizing this encroachment. CVFPB will need to review crossing to determine owner. The UCIP inspection was completed with GEI staff, H.Dunn. (P.Espinoza ? GEI)03/27/2014 Dense vegetation limits the inspector's visibility to identify signs of pipe failure (leaks) along the landward slope. Recommend removing vegetation along pipe alignment to conduct proper inspection of structure. (W. Wylie - DWR UCIP) FIELD_STRUCT_DESC: 30-inch by 30-inch reinforced concrete box gravity drainage culvert (RCBC) through the levee, 13.1 feet below the crown. Flap gate on the waterside (WS) end. Concrete headwall on the landside (LS) end. Concrete U-shaped headwall on the WS end. [Additional Reference(s): DWR Levee Log, 2002, (HLM 30.04). USACE San Joaquin O&M Manual, Unit No. 601, Part No. 1, 1967, Amended in 1978, Revised 20 June 1985, (HLM 30.04). DWR As-Built Specification No. 64-42, Sheet No. 6, 13 August 1964, (HLM 30.04)]. FS Date: 6/24/2021

LS view from toe: concrete headwall at inlet.

LS view from toe: closeup of inlet.

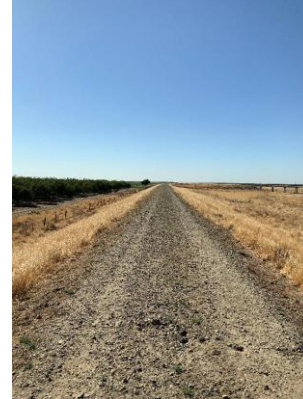
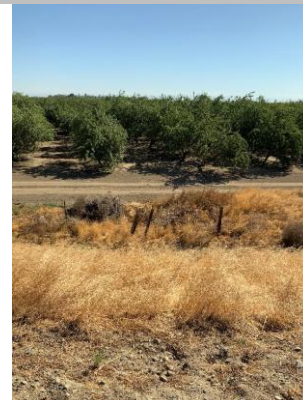
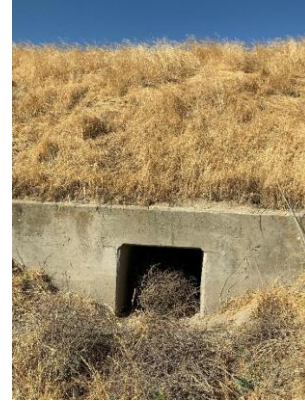
DS_ID:19697
FS_ID:71079
EP_NO: N/A
Repair Type: Non-Urgent
EVAL Issue: 5, Pipe Damage
Crossing Status: Found
UCIP Comments: 09/25/2024 DMP internal video inspection has found moderate pipe defects. Crossing will be monitored until funding becomes available for rehabilitation. (O. Yakimov - DWR UCIP)
06/24/2021 The record remains Non-Urgent. Crossing appears to be in good condition. No permit was found authorizing this encroachment. CVFPB will need to review crossing to determine owner. The UCIP inspection was completed with GEI staff, H.Dunn. (P.Espinoza ? GEI)

03/27/2014 Some debris buildup at LS toe. Dense vegetation limits the inspector's visibility to identify signs of pipe failure (leaks) along the landward slope. Recommend removing vegetation along pipe alignment to conduct proper inspection of structure. (W. Wylie - DWR UCIP)
FIELD_STRUCT_DESC: 30-inch by 30-inch reinforced concrete box gravity drainage culvert (RCBC) through the levee, 13.3 feet below the crown. Flap gate on the waterside (WS) end. Concrete headwall on the landside (LS) end. Concrete U-shaped headwall on the WS end.
[Additional Reference(s): DWR Levee Log, 2002, (HLM 30.97). USACE San Joaquin O&M Manual, Unit No. 601, Part No. 1, 1967, Amended in 1978, Revised 20 June 1985, (HLM 30.96). DWR As-Built Specification No. 64-42, Sheet No. 7, 13 August 1964, (HLM 30.96)].
FS Date: 6/24/2021 3:36:00 PM

Levee crown.

LS view from crown.

LS view from toe: concrete headwall at inlet.

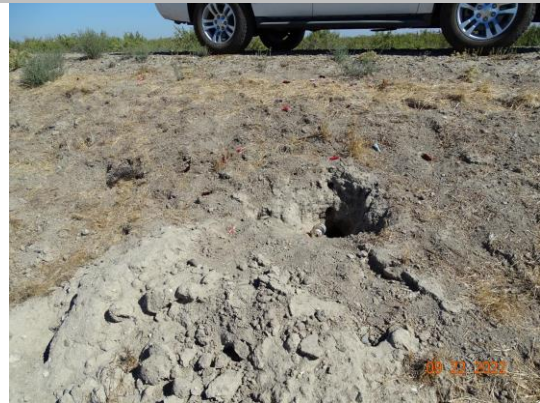
Photo 1 of 1 : FA_2024_NA0010_123_193_20240828_00062.jpg

LM Start	31.17	Rating **	M	Issue No.	193
LM End	31.17	Issue Type +	Ma	Location *	WS
Category	Earthen Levee			GPS Latitude/Longitude	
				Start	End
Item	Animal Control			37.003104°	37.003104°
				-120.417833°	-120.417833°
DWR ID	DWR_NA0010_05_f_2022_193				
Comment Code					
A3 : No rodents visible, but rodent burrows visible; need to backfill and compact or grout burrows.					
Inspector Comment

View of animal burrow in the waterside slope. (Fall 2022)

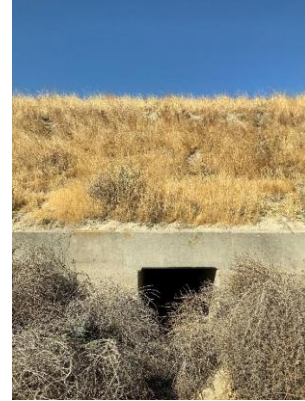
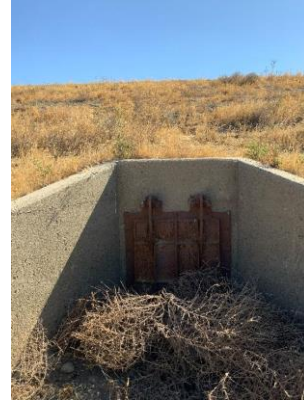
Comment Code						
Inspector Comment						
DS_ID:19698 FS_ID:84966 EP_NO: N/A Repair Type: No Action Needed EVAL Issue: Crossing Status: Found UCIP Comments: 10/07/2024 Record updated from Non-Urgent to No Action Needed. Removed code 12b since pipe is drainage and record source is Levee Log and O&M. Removed code 11 since vegetation is not maintenance of the pipe. (M. Thao - DWR UCIP) 6/24/2021 The record remains Non-Urgent. Some tumbleweed buildup over WS flapgate and LS inlet, recommend removal. No permit was found authorizing this encroachment. CVFPB will need to review crossing to determine owner. The UCIP inspection was completed with GEI staff, H.Dunn. (P.Espinoza ? GEI) 03/27/2014 Excess vegetation buildup at inlet on LS toe. Dense vegetation limits the inspector's visibility to identify signs of pipe failure (leaks) along the landward slope. Recommend removing vegetation along pipe alignment to conduct proper inspection of structure. (W. Wylie - DWR UCIP) FIELD_STRUCT_DESC: 30-inch by 30-inch reinforced concrete box gravity drainage culvert (RCBC) through the levee, 13.4 feet below the crown. Flap gate on the waterside (WS) end. Concrete headwall on the landside (LS) end. Concrete U-shaped headwall on the WS end. [Additional Reference(s): DWR Levee Log, 2002, (HLM 31.20). USACE San Joaquin O&M Manual, Unit No. 601, Part No. 1, 1967, Amended in 1978, Revised 20 June 1985, (HLM 31.19). DWR As-Built Specification No. 64-42, Sheet No. 7, 13 August 1964, (HLM 31.19)]. FS Date: 6/24/2021 2:32:00 PM

LS view from toe: concrete headwall at inlet.

WS view from toe: flapgate on concrete headwall at outlet.

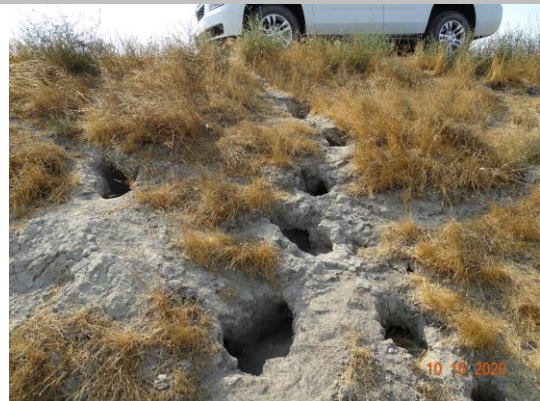
Photo 1 of 1 : FA_2024_NA0010_123_129_20240828_00024.jpg

LM Start	31.70	Rating **	U	Issue No.	129
LM End	31.73	Issue Type +	Ma	Location *	LS
Category	Earthen Levee			GPS Latitude/Longitude	
				Start	End
Item	Animal Control			36.997410 °	36.997108 °
				-120.411437 °	-120.411092 °
DWR ID	DWR_NA0010_05_f_2020_129				
Comment Code					
A3 : No rodents visible, but rodent burrows visible; need to backfill and compact or grout burrows.					
Inspector Comment

Several large rodent holes noted at this location. (Fall 2020)

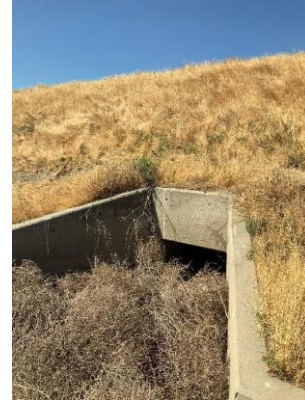
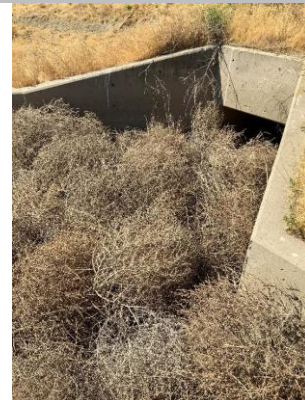
Comment Code						
Inspector Comment						
DS_ID:19699 FS_ID:71081 EP_NO: N/A Repair Type: Non-Urgent EVAL Issue: 11, Maintenance Compliance Issue Crossing Status: Found UCIP Comments: 06/24/2021 The record has been upgraded from No Action Needed to Non-Urgent. Limited inspection of LS due to dense vegetation; recommend removal. Wooden planks propping flapgate on WS open; recommend removal before flood season. No permit was found authorizing this encroachment. CVFPB will need to review crossing to determine owner. The UCIP inspection was completed with GEI staff, H.Dunn. (P.Espinoza ? GEI) FIELD_STRUCT_DESC: 48-inch by 36-inch reinforced concrete box gravity drainage culvert (RCBC) through the levee, 14.5 feet below the crown. Flap gate on the waterside (WS) end. Concrete U-shaped headwall on each end. [Additional Reference(s): DWR Levee Log, 2002, (HLM 31.64). USACE San Joaquin O&M Manual, Unit No. 601, Part No. 1, 1967, Amended in 1978, Revised 20 June 1985, (HLM 31.64). DWR As-Built Specification No. 64-42, Sheet No. 8, 13 August 1964, (HLM 31.64)]. FS Date: 6/24/2021 2:15:00 PM

LS view from toe: concrete headwall at inlet.

LS view from toe: closeup of inlet.

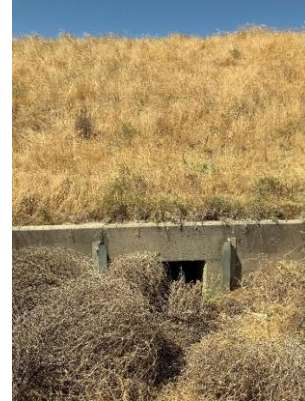
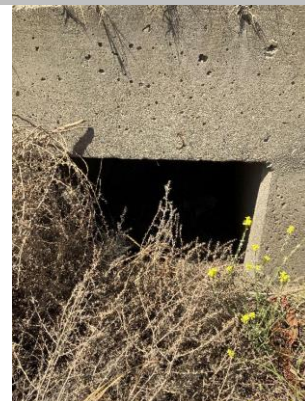
DS_ID:19701
FS_ID:71083
EP_NO: N/A
Repair Type: Non-Urgent
EVAL Issue: 5, Pipe Damage
Crossing Status: Found
UCIP Comments: 09/25/2024 DMP internal video inspection has found moderate pipe defects. Crossing will be monitored until funding becomes available for rehabilitation. (O. Yakimov - DWR UCIP)
06/23/2021 The record remains Non-Urgent. Limited inspection of LS inlet due to dense vegetation; recommend removal. No permit was found authorizing this encroachment. CVFPB will need to review crossing to determine owner. The UCIP inspection was completed with GEI staff, H.Dunn. (P.Espinoza ? GEI) 04/01/2014 Some silt buildup inside culvert. (W. Wylie - DWR UCIP)
FIELD_STRUCT_DESC: 30-inch by 30-inch reinforced concrete box gravity drainage culvert (RCBC) through the levee, 14.2 feet below the crown. Flap gate on the waterside (WS) end. Concrete headwall on the landside (LS) end with flashboard attachment. Concrete U-shaped headwall on the WS end. [Additional Reference(s): DWR Levee Log, 2002, (HLM 32.22). USACE San Joaquin O&M Manual, Unit No. 601, Part No. 1, 1967, Amended in 1978, Revised 20 June 1985, (HLM 32.22). DWR As-Built Specification No. 64-42, Sheet No. 8, 13 August 1964, (HLM 32.22)].

LS view from toe: concrete headwall at inlet.

LS view from toe: closeup of inlet.

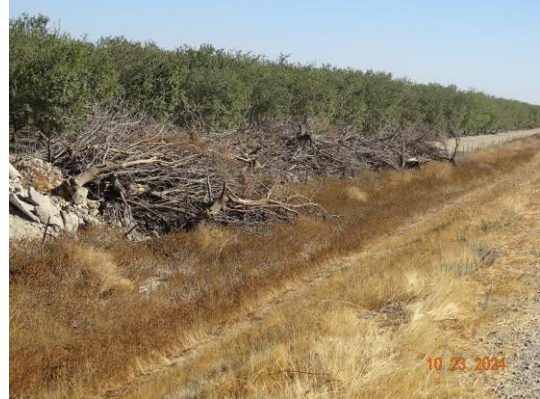
Photo 1 of 1 : FA_2024_NA0010_123_196_20241105_00297.jpg

LM Start	33.08	Rating **	M	Issue No.	196
LM End	33.08	Issue Type +	En	Location *	LS
Category	Earthen Levee			GPS Latitude/Longitude	
				Start	End
Item	Encroachments			36.981182 °	36.981182 °
				-120.393448 °	-120.393448 °
DWR ID	DWR_NA0010_05_f_2022_196				
Comment Code					
DE : Debris					
Inspector Comment					
Tree prunings and material are beginning to encroach the levee easement and landside toe.

Debris encroaching into the landside easement and toe. (Fall 2024)

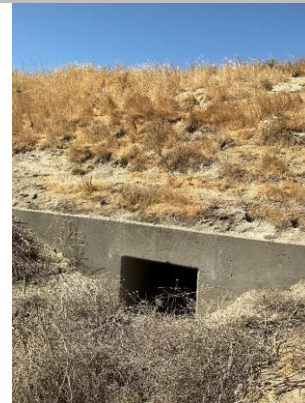
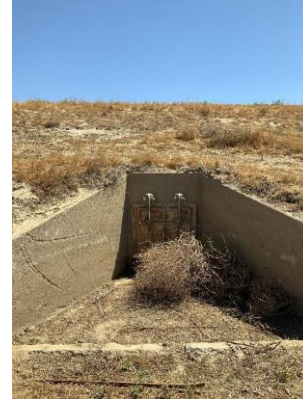
Comment Code						
Inspector Comment						
DS_ID:19702 FS_ID:71084 EP_NO: N/A Repair Type: Non-Urgent EVAL Issue: 11, Maintenance Compliance Issue Crossing Status: Found UCIP Comments: 06/23/2021 The record remains Non-Urgent. Some tumbleweed buildup over WS flapgate and LS inlet, recommend removal. No permit was found authorizing this encroachment. CVFPB will need to review crossing to determine owner. The UCIP inspection was completed with GEI staff, H.Dunn. (P.Espinoza ? GEI) 04/01/2014 Dense vegetation limits the inspector's visibility to identify signs of pipe failure (leaks) along the landward slope. Recommend removing vegetation along pipe alignment to conduct proper inspection of structure. Debris buildup blocking landward headwall--recommend contacting owner to clear debris. (W. Wylie - DWR UCIP) FIELD_STRUCT_DESC: 30-inch by 30-inch reinforced concrete box gravity drainage culvert (RCBC) through the levee, 12.2 feet below the crown. Flap gate on the waterside (WS) end. Concrete headwall on the landside (LS) end. Concrete U-shaped headwall on the WS end. [Additional Reference(s): DWR Levee Log, 2002, (HLM 33.02). USACE San Joaquin O&M Manual, Unit No. 601, Part No. 1, 1967, Amended in 1978, Revised 20 June 1985, (HLM 33.01). DWR As-Built Specification No. 64-42, Sheet No. 9, 13 August 1964, (HLM 33.01)]. FS Date: 6/23/2021 12:49:00 PM

LS view from toe: concrete headwall at inlet.

WS view from toe: flapgate on concrete headwall at outlet.

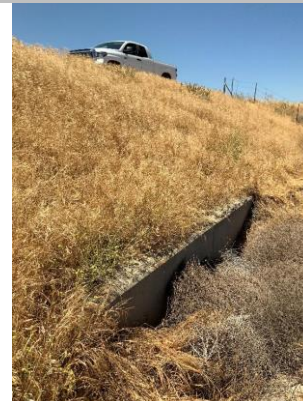
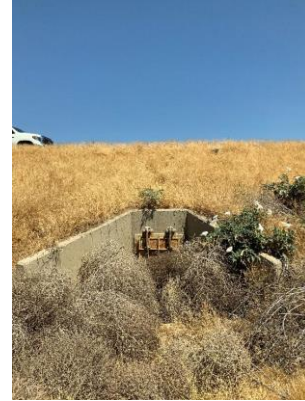
DS_ID:19703
FS_ID:71085
EP_NO: N/A
Repair Type: Non-Urgent
EVAL Issue: 11, Maintenance Compliance Issue
Crossing Status: Found
UCIP Comments: 06/24/2021 The record remains Non-Urgent. Limited inspection of LS and WS due to dense vegetation; recommend removal. No permit was found authorizing this encroachment. CVFPB will need to review crossing to determine owner. The UCIP inspection was completed with GEI staff, H.Dunn. (P.Espinoza ? GEI)

04/01/2014 Dense vegetation limits the inspector's visibility to identify signs of pipe failure (leaks) along the slopes. Recommend removing vegetation along pipe alignment to conduct proper inspection of structure. (W. Wylie - DWR UCIP)
FIELD_STRUCT_DESC: 30-inch by 30-inch reinforced concrete box gravity drainage culvert (RCBC) through the levee, 13.9 feet below the crown. Flap gate on the waterside (WS) end. Concrete headwall on the landside (LS) end. Concrete U-shaped headwall on the WS end.
[Additional Reference(s): DWR Levee Log, 2002, (HLM 33.72). USACE San Joaquin O&M Manual, Unit No. 601, Part No. 1, 1967, Amended in 1978, Revised 20 June 1985, (HLM 33.72). DWR As-Built Specification No. 64-42, Sheet No. 9, 13 August 1964, (HLM 33.72)].
FS Date: 6/24/2021 12:30:00 PM

LS view from toe: concrete headwall and inlet.

WS view from toe: flapgate on concrete headwall.

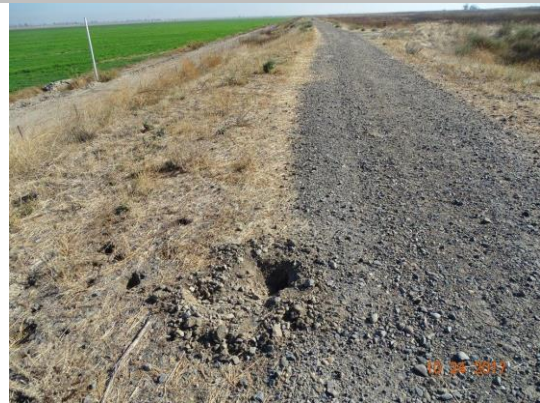
Photo 1 of 1 : FA_2024_NA0010_123_130_20240828_00025.jpg

LM Start	33.82	Rating **	M	Issue No.	130
LM End	33.82	Issue Type +	Ma	Location *	LS
Category	Earthen Levee			GPS Latitude/Longitude	
				Start	End
Item	Animal Control			36.976849 °	36.976849 °
				-120.382393 °	-120.382393 °
DWR ID	DWR_NA0010_05_f_2017_130				
Comment Code					
A3 : No rodents visible, but rodent burrows visible; need to backfill and compact or grout burrows.					
Inspector Comment

Looking east at the landside shoulder.

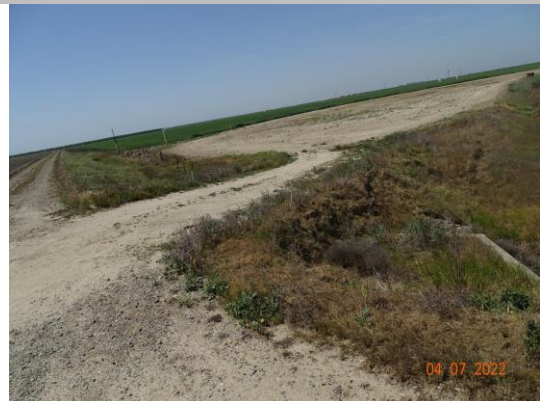
Photo 1 of 1 : FA_2024_NA0010_123_189_20240828_00059.jpg

LM Start	34.60	Rating **	M	Issue No.	189
LM End	34.60	Issue Type +	En	Location *	LS
Category	Earthen Levee			GPS Latitude/Longitude	
				Start	End
Item	Encroachments			36.978525 °	36.978525 °
				-120.368661 °	-120.368661 °
DWR ID	DWR_NA0010_05_s_2022_189				
Comment Code					
RA : Ramp					
Inspector Comment

View of ramp on the landside slope. (Spring 2022)

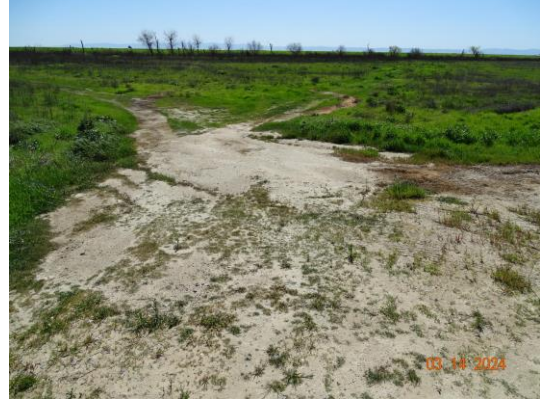
Photo 1 of 1 : FA_2024_NA0010_123_11_20240828_00006.jpg

LM Start	34.61	Rating **	M	Issue No.	11
LM End	34.61	Issue Type +	En	Location *	WS
Category	Earthen Levee			GPS Latitude/Longitude	
				Start	End
Item	Encroachments			36.978523 °	36.978523 °
				-120.368520 °	-120.368520 °
DWR ID	DWR_NA0010_05_s_2012_11				
Comment Code					
RA : Ramp					
Inspector Comment					
There is an unauthorized ramp on waterside slope. Landowner cut unauthorized ramp on waterside slope and levee crown.

Looking west at ramp on waterward slope. (Spring 2024)

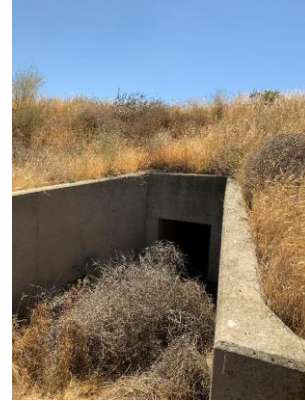
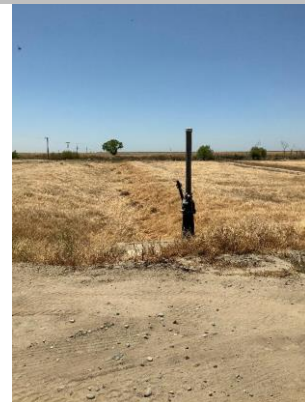
DS_ID:19755
FS_ID:71086
EP_NO: N/A
Repair Type: Non-Urgent
EVAL Issue: 11, Maintenance Compliance Issue
Crossing Status: Found
UCIP Comments: 06/24/2021 The record remains Non-Urgent. Limited inspection of WS and LS due to dense vegetation, recommend removal. No permit was found authorizing this encroachment. CVFPB will need to review crossing to determine owner. The UCIP inspection was completed with GEI staff, H.Dunn. (P.Espinoza ? GEI)

04/01/2014 Dense vegetation limits the inspector's visibility to identify signs of pipe failure (leaks) along the landward slope. Recommend removing vegetation along pipe alignment to conduct proper inspection of structure. Debris buildup visible on waterward headwall--recommend contacting owner to clear pipe. (W. Wylie - DWR UCIP)
FIELD_STRUCT_DESC: [Chowchilla Canal Irrigation Structure] 36-inch by 36-inch reinforced concrete box gravity irrigation culvert (RCBC) through the levee, 9.7 feet below the crown. Slide gate in a 56-inch by 91-inch concrete riser unit on the waterside (WS) slope. Concrete U-shaped headwall on each end. Landside channel cobble revetted for 8 feet. [Additional Reference(s): DWR Levee Log, 2002, (HLM 34.51). USACE San Joaquin O&M Manual, Unit No. 601, Part No. 1, 1967, Amended in 1978, Revised 20 June 1985, (HLM 34.51). DWR As-Built Specification No. 64-42, Sheet No. 10, 13 August 1964, (HLM 34.51)].

LS view from toe: concrete headwall and inlet.

WS view from crown. Slide gate in concrete riser visible in background.

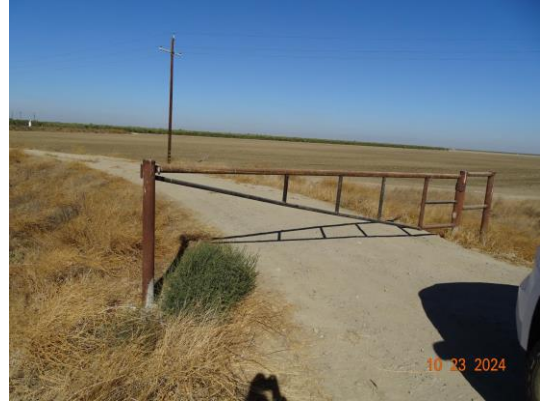
Photo 1 of 1 : FA_2024_NA0010_123_111_20241105_00298.jpg

LM Start	34.61	Rating **	U	Issue No.	111
LM End	34.61	Issue Type +	En	Location *	CR
Category	Earthen Levee			GPS Latitude/Longitude	
				Start	End
Item	Encroachments			36.978587 °	36.978587 °
				-120.368469 °	-120.368469 °
DWR ID	DWR_NA0010_05_f_2024_111				
Comment Code					
FE : Fence					
Inspector Comment

New fence installed across the levee crown. District does not have a lock in the daisy-chain. (Fall 2024)

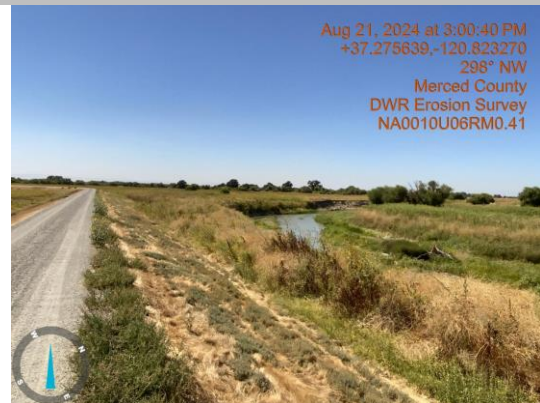
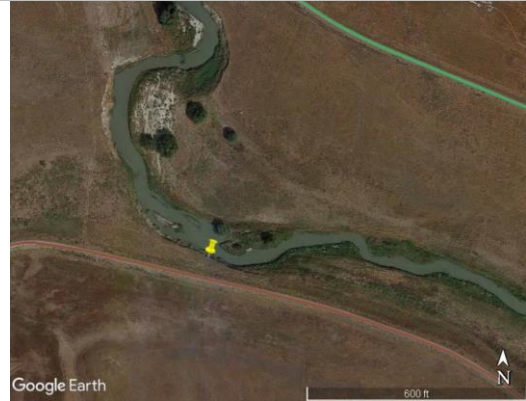
LM Start	0.10	Rating **	U	Issue No.	2
LM End	0.14	Issue Type +	Ma	Location *	WS
Category	Supplemental			GPS Latitude/Longitude	
				Start	End
Item	DWR Erosion Survey			37.275701 °	37.275701 °
				-120.823773 °	-120.823773 °
DWR ID	NA0010U06RM0.41				
Comment Code					
Inspector Comment					
Site ID: NA0010U06RM0.41					
8/21/2024: From 2022 to present, no significant changes were observed during the annual survey.					
08/09/2022: The site was discovered by the LMA and visited during the annual field survey. There is a 20-ft vertical scarp running along the bank and encroaching into the extended levee prism. The berm is 10-12 ft wide.

8/21/2024: View of the erosion looking downstream.

9/13/2022: Aerial view of the erosion site (Google Earth Imagery from 9/27/2020).

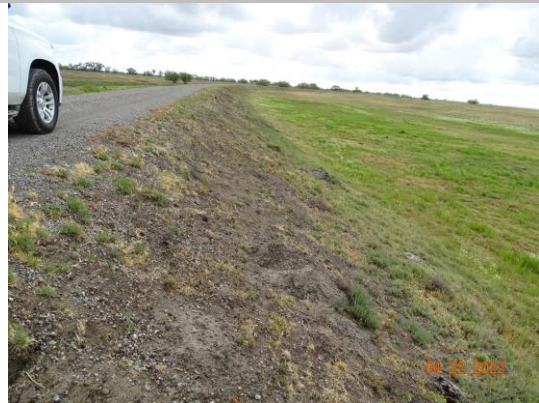
Photo 1 of 1 : FA_2024_NA0010_124_147_20240828_00065.jpg

LM Start	0.14	Rating **	A/W	Issue No.	147
LM End	0.14	Issue Type +	Ma	Location *	LS
Category	Earthen Levee			GPS Latitude/Longitude	
				Start	End
Item	Animal Control			37.275637 °	37.275637 °
				-120.823438 °	-120.823438 °
DWR ID	DWR_NA0010_06_s_2022_147				
Comment Code					
A3 : No rodents visible, but rodent burrows visible; need to backfill and compact or grout burrows.					
Inspector Comment

View of rodent burrows on the landside slope. (Spring 2022)

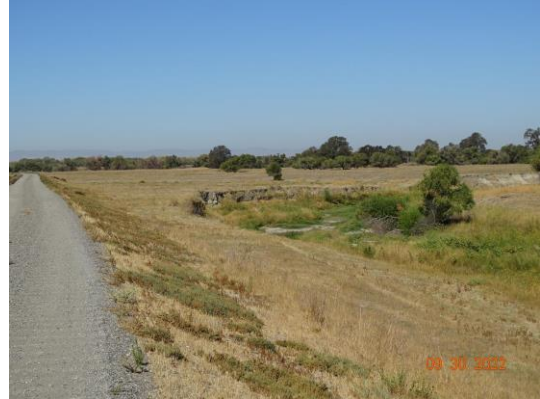
Photo 1 of 1 : FA_2024_NA0010_124_106_20240828_00035.jpg

LM Start	0.14	Rating **	A/W	Issue No.	106
LM End	0.17	Issue Type +	Ma	Location *	WS
Category	Earthen Levee			GPS Latitude/Longitude	
				Start	End
Item	Erosion / Bank Caving			37.275640 °	37.275541 °
				-120.823419 °	-120.822833 °
DWR ID	DWR_NA0010_06_f_2022_106				
Comment Code					
E2 : Schedule repair of erosion site prior to the next inspection.					
Inspector Comment					
Erosion is approximately 10 feet from toe. It is within the theoretical prism. Erosion is approximately 20 feet in height and 250 feet in length.

Erosion on the waterside toe has cut into the theoretical prism. (Fall 2022)

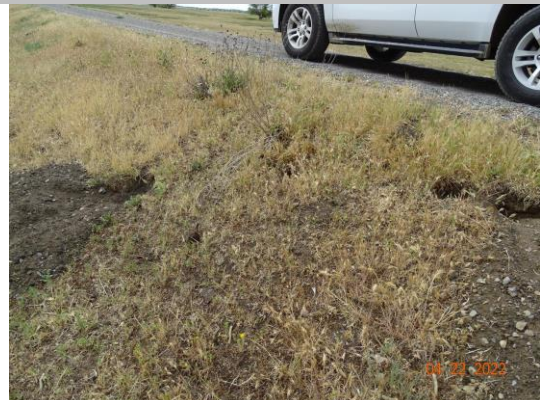
Photo 1 of 1 : FA_2024_NA0010_124_148_20240828_00066.jpg

LM Start	0.43	Rating **	A/W	Issue No.	148
LM End	0.43	Issue Type +	Ma	Location *	WS
Category	Earthen Levee			GPS Latitude/Longitude	
				Start	End
Item	Animal Control			37.273651 °	37.273651 °
				-120.818813 °	-120.818813 °
DWR ID	DWR_NA0010_06_s_2022_148				
Comment Code					
A1 : Exterminate rodents and backfill and compact or grout burrows.					
Inspector Comment

View of active rodent burrows on waterside slope. (Spring 2022)

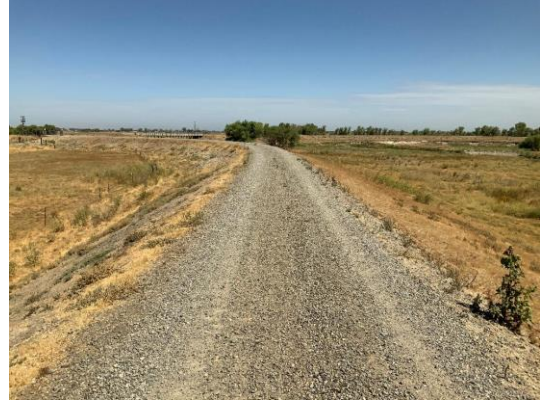
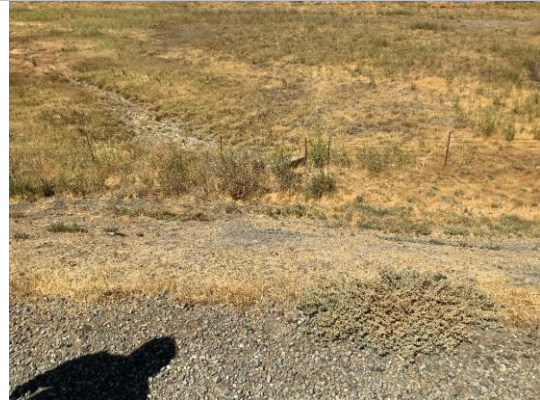
Comment Code						
Inspector Comment						
DS_ID:19816 FS_ID:71092 EP_NO: N/A Repair Type: Non-Urgent EVAL Issue: Crossing Status: Found UCIP Comments: 07/27/2021 The record remains Non-Urgent. LS pipe inlet is blocked by barbed wire, limited access and inspection. No permit was found authorizing this encroachment. CVFPB will need to review crossing to determine owner. The UCIP inspection was completed with GEI staff, P. Espinoza. (H. Dunn ? GEI)04/18/2014 Landward side blocked--need to contact owner to determine status of crossing. (O. Magana - DWR UCIP) FIELD_STRUCT_DESC: 24-inch corrugated metal gravity drainage pipe (CMP) through the levee, 16.2 feet below the crown. Flap gate on the waterside (WS) end. Concrete U-shaped headwall on each end. [Additional Reference(s): DWR Levee Log, 2002, (HLM 0.86). USACE San Joaquin O&M Manual, Unit No. 601, Part No. 1, 1967, Amended in 1978, Revised 20 June 1985, (HLM 0.86). DWR As-Built Specification No. 61-01, Sheet No. 45, 7 March 1961, (HLM 0.86)]. FS Date: 7/27/2021

Levee crown.

LS view: Toe from crown.

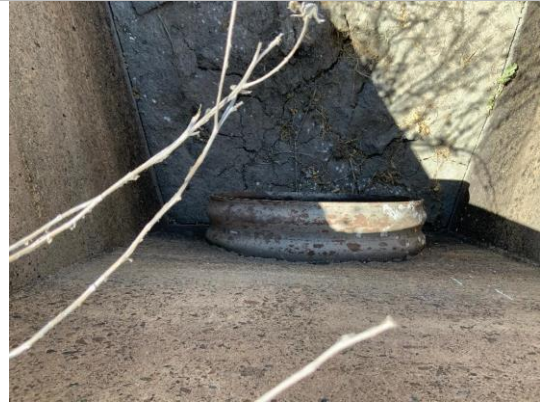
Photo 3 of 3 : UCIP_FA_2024_71092_102879.jpg

LS view: Top view of pipe inlet at toe.

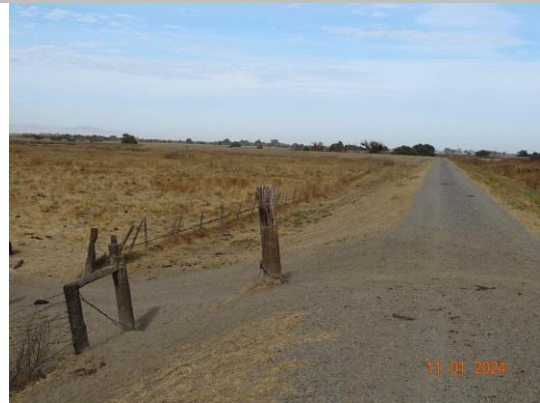
Photo 1 of 1 : FA_2024_NA0010_124_104_20241105_00147.jpg

LM Start	1.26	Rating **	A/W	Issue No.	104
LM End	1.26	Issue Type +	Ma	Location *	LS
Category	Earthen Levee			GPS Latitude/Longitude	
				Start	End
Item	Erosion / Livestock			37.266117 °	37.266117 °
				-120.808629 °	-120.808629 °
DWR ID	DWR_NA0010_06_f_2024_104				
Comment Code					
E4 : Repair the levee slope damaged by livestock and prevent large animal access.					
Inspector Comment

View of erosion on the landside slope. (Fall 2024)

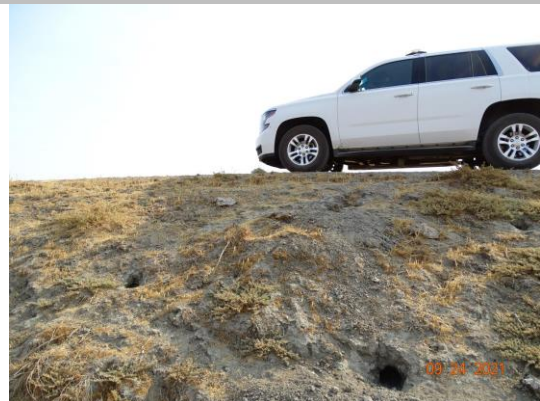
Photo 1 of 1 : FA_2024_NA0010_124_127_20240828_00050.jpg

LM Start	1.52	Rating **	M	Issue No.	127
LM End	1.52	Issue Type +	Ma	Location *	LS
Category	Earthen Levee			GPS Latitude/Longitude	
				Start	End
Item	Animal Control			37.263176 °	37.263176 °
				-120.805983 °	-120.805983 °
DWR ID	DWR_NA0010_06_f_2021_127				
Comment Code					
A3 : No rodents visible, but rodent burrows visible; need to backfill and compact or grout burrows.					
Inspector Comment

View of rodent burrows in the landside slope. (Fall 2021)

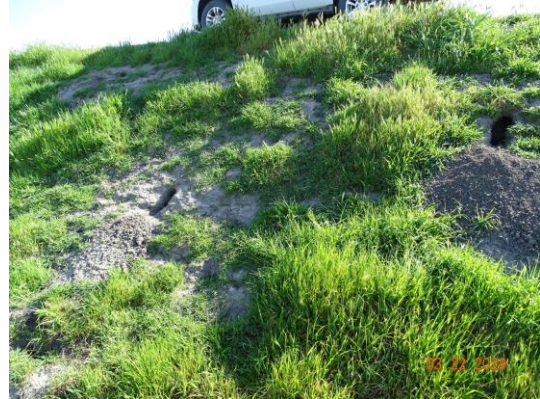
Photo 1 of 1 : FA_2024_NA0010_124_58_20240828_00012.jpg

LM Start	1.60	Rating **	M	Issue No.	58
LM End	1.60	Issue Type +	Ma	Location *	LS
Category	Earthen Levee			GPS Latitude/Longitude	
				Start	End
Item	Animal Control			37.261952°	37.261952°
				-120.805894°	-120.805894°
DWR ID	DWR_NA0010_06_s_2024_58				
Comment Code					
A3 : No rodents visible, but rodent burrows visible; need to backfill and compact or grout burrows.					
Inspector Comment

View of multiple rodent burrows on the landside slope. (Spring 2024)

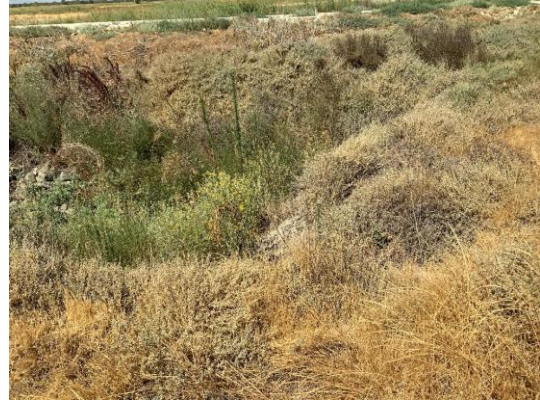
Photo 1 of 1 : UCIP_FA_2024_84970_102904.jpg

Comment Code						
Inspector Comment						
DS_ID:19817 FS_ID:84970 EP_NO: N/A Repair Type: Non-Urgent EVAL Issue: Crossing Status: Found UCIP Comments: 09/25/2023 Pipe was CIPP-lined. DMP internal video inspection has found none or minor pipe defects. Recommend next video inspection in 5 years. (J. Taylor - DWR UCIP) 7/27/2021 The record remains Non-Urgent. LS pipe inlet inaccessible due to barbed wire and not visible due to dense vegetation, limited inspection and recommend removing vegetation. No permit was found authorizing this encroachment. CVFPB will need to review crossing to determine owner. The UCIP inspection was completed with GEI staff, P. Espinoza. (H. Dunn ? GEI) 04/18/2014 No access was available to landward side due to fence. Recommend removing some of the vegetation on waterward toe. (O. Magana - DWR UCIP) FIELD_STRUCT_DESC: 24-inch CIPP-lined corrugated metal gravity drainage pipe (CMP) through the levee, 13.5 feet below the crown. Flap gate on the waterside (WS) end. Concrete headwall on each end. [Additional Reference(s): DWR Levee Log, 2002, (HLM 1.96). USACE San Joaquin O&M Manual, Unit No. 601, Part No. 1, 1967, Amended in 1978, Revised 20 June 1985, (HLM 1.95). DWR As-Built Specification No. 61-01, Sheet No. 46, 7 March 1961, (HLM 1.95)]. FS Date: 7/27/2021

LS view: Inlet hidden by dense vegetation at toe.

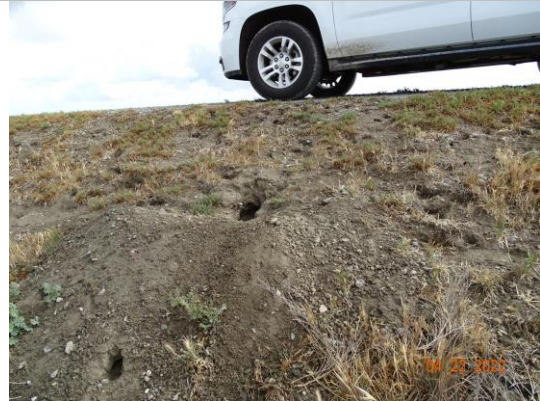
Photo 1 of 1 : FA_2024_NA0010_124_146_20240828_00064.jpg

LM Start	2.19	Rating **	M	Issue No.	146
LM End	2.25	Issue Type +	Ma	Location *	LS
Category	Earthen Levee			GPS Latitude/Longitude	
				Start	End
Item	Animal Control			37.256733 °	37.256252 °
				-120.797941 °	-120.797223 °
DWR ID	DWR_NA0010_06_s _ 2022_146				
Comment Code					
A3 : No rodents visible, but rodent burrows visible; need to backfill and compact or grout burrows.					
Inspector Comment					
A few rodent burrows observed in this section with large quantities of material displaced.

View of rodent holes on the landside slope. (Spring 2022)

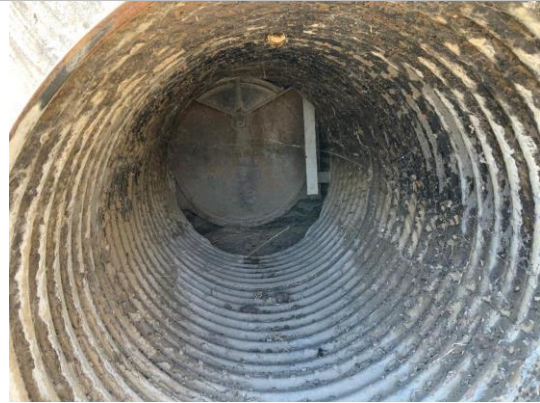
Photo 1 of 1 : UCIP_FA_2024_71094_102912.jpg

Comment Code					
Inspector Comment					
DS_ID:19818 FS_ID:71094 EP_NO: N/A Repair Type: Non-Urgent EVAL Issue: 5, Pipe Damage Crossing Status: Found UCIP Comments: 07/27/2021 The record remains Non-Urgent. DWR DMP internal inspection has found pipe integrity issues. LOF of crossing is between 4.1 and 5. Crossing will be monitored until funding becomes available for rehabilitation. No permit was found authorizing this encroachment. CVFPB will need to review crossing to determine owner. The UCIP inspection was completed with GEI staff, P. Espinoza. (H. Dunn ? GEI)04/18/2014 Need to contact owner. Sediment buildup in pipe visible on landward side. (O. Magana - DWR UCIP) FIELD_STRUCT_DESC: 36-inch corrugated metal gravity drainage pipe (CMP) through the levee, 6.9 feet below the crown. Slide gate in a 48-inch CMP riser unit on the waterside (WS) slope. Concrete headwall on each end. [Additional Reference(s): DWR Levee Log, 2002, (HLM 2.61). USACE San Joaquin O&M Manual, Unit No. 601, Part No. 1, 1967, Amended in 1978, Revised 20 June 1985, (HLM 2.61). DWR As-Built Specification No. 61-01, Sheet No. 46, 7 March 1961, (HLM 2.61)]. FS Date: 7/27/2021

WS view: Inside pipe outlet at toe.

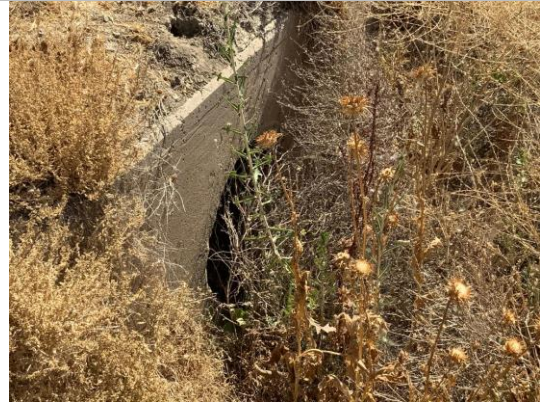
Photo 1 of 1 : UCIP_FA_2024_71095_102921.jpg

Comment Code						
Inspector Comment						
DS_ID:19819 FS_ID:71095 EP_NO: N/A Repair Type: Non-Urgent EVAL Issue: Crossing Status: Found UCIP Comments: 09/18/2023 Pipe was CIPP lined. DMP internal video inspection has found none or minor pipe defects. Recommend next video inspection in 5 years. (O. Yakimov - DWR UCIP) 07/27/2021 The record remains Non-Urgent. DWR DMP internal inspection has found pipe integrity issues. LOF of crossing is between 4.1 and 5. Crossing will be monitored until funding becomes available for rehabilitation. Dense vegetation covering LS pipe inlet, limited inspection and recommend removal. No permit was found authorizing this encroachment. CVFPB will need to review crossing to determine owner. The UCIP inspection was completed with GEI staff, P. Espinoza. (H. Dunn ? GEI)04/18/2014 Dense vegetation limits the inspector's visibility to identify signs of pipe condition on landward toe--headwall blocked by dense vegetation. Recommend removing vegetation from landward toe. (O. Magana - DWR UCIP) FIELD_STRUCT_DESC: 24-inch CIPP-lined corrugated metal gravity drainage pipe (CMP) through the levee, 9.2 feet below the crown. Flap gate on the waterside (WS) end. Concrete headwall on each end. [Additional Reference(s): DWR Levee Log, 2002, (HLM 2.65). USACE San Joaquin O&M Manual, Unit No. 601, Part No. 1, 1967, Amended in 1978, Revised 20 June 1985, (HLM 2.65). DWR As-Built Specification No. 61-01, Sheet No. 46, 7 March 1961, (HLM 2.65)]. FS Date: 7/27/2021

LS view: Closeup of pipe inlet at toe with dense vegetation.

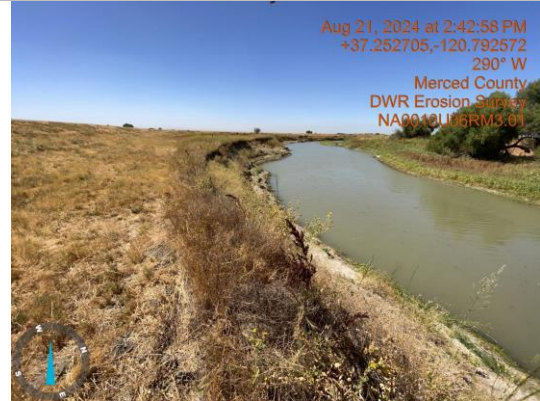
Photo 1 of 2 : SJR2024_NA0010U06RM3.01_5.JPG

LM Start	2.61	Rating **	U	Issue No.	1
LM End	2.68	Issue Type +	Ma	Location *	WS
Category	Supplemental			GPS Latitude/Longitude	
				Start	End
Item	DWR Erosion Survey			37.252596°	37.252596°
				-120.792504°	-120.792504°
DWR ID	NA0010U06RM3.01				
Comment Code					
Inspector Comment					
Site ID: NA0010U06RM3.01					
8/21/2024: From 2022 to present, no significant changes were observed during the annual survey.					
08/09/2022: The site was discovered by the LMA and visited during the annual field survey. There is a 15-20 ft scarp, vertical in some locations, running along the bank. The berm is 15 ft wide at the narrowest section.

8/21/2024: View of the erosion looking upstream.

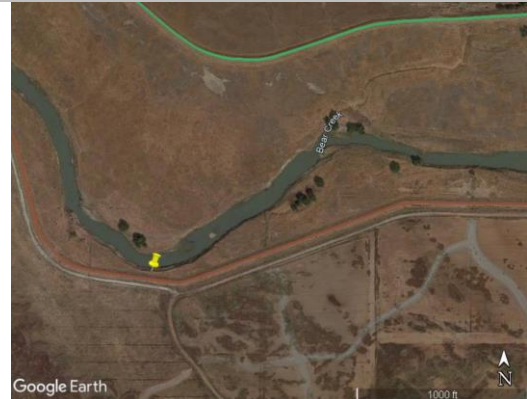
Photo 2 of 2 : SJR2024_NA0010U06LM2.64_GE.jpg

9/13/2022: Aerial view of the erosion site (Google Earth Imagery from 9/27/2020).

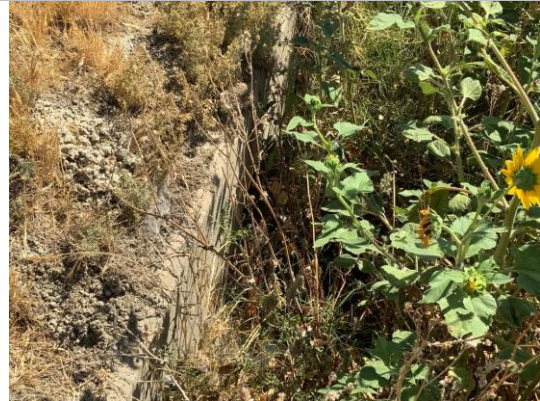
Photo 1 of 2 : UCIP_FA_2024_77923_102930.jpg

Comment Code						
Inspector Comment						
DS_ID:19820 FS_ID:77923 EP_NO: N/A Repair Type: Non-Urgent EVAL Issue: 6, Levee Damage or Threat for Levee Damage Crossing Status: Found UCIP Comments: 12/20/2022 Record updated from Urgent to Non-Urgent. Pipe has been CIPP lined. LOF of crossing is less or equal to 4. Recommend next video inspection in 5 years. (O.Yakimov - DWR UCIP) 07/27/2021 The record has been upgraded from Non-Urgent to Urgent. DWR DMP internal inspection has found pipe integrity issues. LOF of crossing is greater than or equal to 5 and less than 6. Crossing will be monitored until funding becomes available to address the issues. Dense vegetation covering LS pipe inlet, limited inspection and recommend removal of vegetation. Some minor erosion under WS concrete pad, less than a foot in length. No permit was found authorizing this encroachment. CVFPB will need to review crossing to determine owner. The UCIP inspection was completed with GEI staff, P. Espinoza. (H. Dunn ? GEI)04/18/2014 Dense vegetation limits the inspector's visibility to identify signs of pipe condition on landward toe--headwall blocked by dense vegetation. Recommend removing vegetation from landward toe. (O. Magana - DWR UCIP) FIELD_STRUCT_DESC: 24-inch CIPP-lined corrugated metal gravity drainage pipe (CMP) through the levee, 10.5 feet below the crown. Flap gate on the waterside (WS) end. Concrete headwall on each end. [Additional Reference(s): DWR Levee Log, 2002, (HLM 2.85). USACE San Joaquin O&M Manual, Unit No. 601, Part No. 1, 1967, Amended in 1978, Revised 20 June 1985, (HLM 2.85). DWR As-Built Specification No. 61-01, Sheet No. 47, 7 March 1961, (HLM 2.85)]. FS Date: 7/27/2021 10:45:23 AM

LS view: Closeup of pipe inlet at toe covered with vegetation.

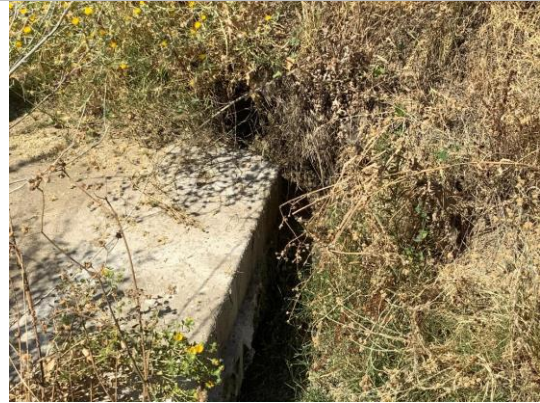
Photo 2 of 2 : UCIP_FA_2024_77923_102927.jpg

WS view: Some erosion underneath concrete pad.

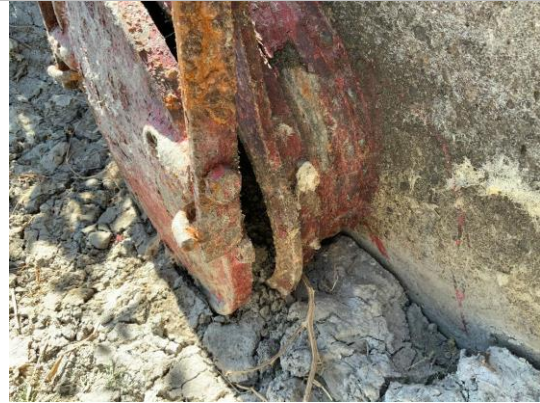
Photo 2 of 2 : UCIP_FA_2024_71097_102943.jpg

DS_ID:19821
FS_ID:71097
EP_NO: N/A
Repair Type: Non-Urgent
EVAL Issue: 11, Maintenance Compliance Issue
Crossing Status: Found
UCIP Comments: 07/27/2021 The record remains Non-Urgent. Limited inspection due to sediment and debris buildup inside LS pipe inlet, recommend removal. Sediment buildup keeping WS flapgate open, recommend removal. No permit was found authorizing this encroachment. CVFPB will need to review crossing to determine owner. The UCIP inspection was completed with GEI staff, P. Espinoza. (H. Dunn ? GEI)04/18/2014 Dense vegetation limits the inspector's visibility to identify signs of pipe condition on landward toe--headwall blocked by dense vegetation. Recommend removing vegetation from landward toe. (O. Magana - DWR UCIP)
FIELD_STRUCT_DESC: 24-inch corrugated metal gravity drainage pipe (CMP) through the levee, 11.2 feet below the crown. Flap gate on the waterside (WS) end. Concrete headwall on each end. [Additional Reference(s): DWR Levee Log, 2002, (HLM 3.09). USACE San Joaquin O&M Manual, Unit No. 601, Part No. 1, 1967, Amended in 1978, Revised 20 June 1985, (HLM 3.09). DWR As-Built Specification No. 61-01, Sheet No. 47, 7 March 1961, (HLM 3.09)].

WS view: Closeup of flapgate at toe with sediment buildup keeping it open, 2 of 2 photos.

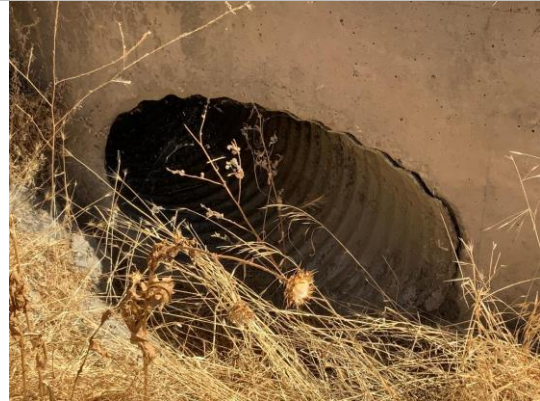
Photo 1 of 2 : UCIP_FA_2024_71098_102955.jpg

Comment Code						
Inspector Comment						
DS_ID:19822 FS_ID:71098 EP_NO: N/A Repair Type: No Action Needed EVAL Issue: Crossing Status: Found UCIP Comments: 09/18/2023 Record updated from Non-Urgent to No Action Needed. Pipe was CIPP lined. DMP internal video inspection has found none or minor pipe defects. Recommend next video inspection in 5 years. (O. Yakimov - DWR UCIP) 07/27/2021 The record remains Non-Urgent. DWR DMP internal inspection has found pipe integrity issues. LOF of crossing is between 4.1 and 5. Crossing will be monitored until funding becomes available for rehabilitation. There is minor separation of the CMP and concrete headwall on the LS toe. No permit was found authorizing this encroachment. CVFPB will need to review crossing to determine owner. The UCIP inspection was completed with GEI staff, P. Espinoza. (H. Dunn ? GEI)04/18/2014 Dense vegetation limits the inspector's visibility to identify signs of pipe condition on waterward slope and landward toe (headwall blocked by dense vegetation). Recommend removing vegetation from landward toe. (O. Magana - DWR UCIP) FIELD_STRUCT_DESC: 24-inch CIPP-lined corrugated metal gravity drainage pipe (CMP) through the levee, 10.4 feet below the crown. Flap gate on the waterside (WS) end. Concrete headwall on each end. [Additional Reference(s): DWR Levee Log, 2002, (HLM 3.29). USACE San Joaquin O&M Manual, Unit No. 601, Part No. 1, 1967, Amended in 1978, Revised 20 June 1985, (HLM 3.29). DWR As-Built Specification No. 61-01, Sheet No. 47, 7 March 1961, (HLM 3.29)]. FS Date: 7/27/2021

LS view: Closeup of pipe inlet at toe.
