Flood Control Project Maintenance Levee Inspections

Fall 2024 Levee Maintenance Deficiency Summary Report

San Joaquin River Basin

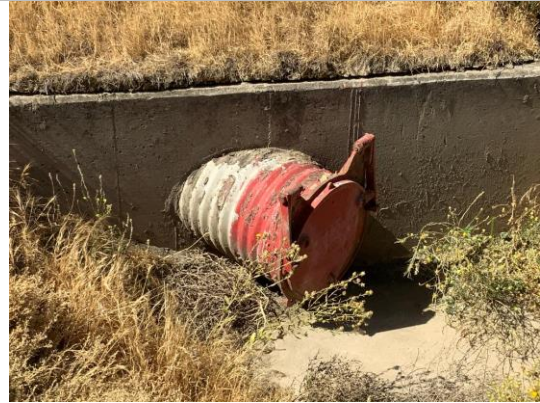
Photo 2 of 2 : UCIP_FA_2024_71098_102951.jpg

WS view: Closeup of flapgate at toe.

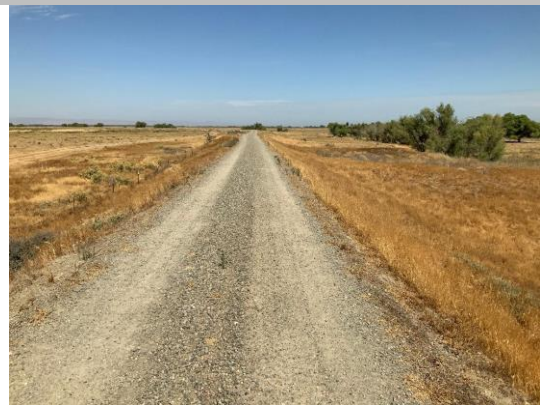
Photo 1 of 3 : UCIP_FA_2024_84929_102957.jpg

DS_ID:19823
FS_ID:84929
EP_NO: N/A
Repair Type: Non-Urgent
EVAL Issue:
Crossing Status: Not Found
UCIP Comments: 07/27/2021 The record remains Non-Urgent. No signs of pipe, headwalls, or flapgate found on WS or LS. Confirm with owner on the status of this pipe. No permit was found authorizing this encroachment. CVFPB will need to review crossing to determine owner. The UCIP inspection was completed with GEI staff, P. Espinoza. (H. Dunn ? GEI)04/18/2014 Alignment of crossing unknown--altered crossing. No headwall found on landward side only siphon breaker found a short distance from landward toe. Tall grass observed on waterward slope and some burrow activity also noticed. Need to contact owner to determine alignment of crossing and status of crossing. (O. Magana - DWR UCIP)
FIELD_STRUCT_DESC: 36-inch corrugated metal gravity drainage pipe (CMP) through the levee, 15.7 feet below the crown. Flap gate on the waterside (WS) end. Concrete U-shaped headwall on each end. Bench mark (BM) stamped 9770-152 on top of the WS headwall. [Additional Reference(s): DWR Levee Log, 2002, (HLM 3.44). USACE San Joaquin O&M Manual, Unit No. 601, Part No. 1, 1967, Amended in 1978, Revised 20 June 1985, (HLM 3.43). DWR As-Built Specification No. 61-01, Sheet No. 47, 7 March 1961, (HLM 3.43)].

Levee crown.

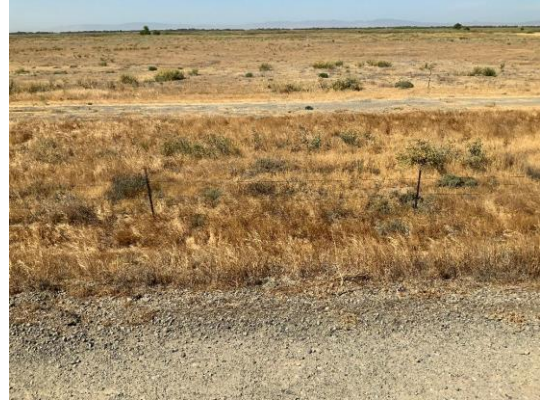
Photo 2 of 3 : UCIP_FA_2024_84929_102958.jpg

LS view: Toe from crown.

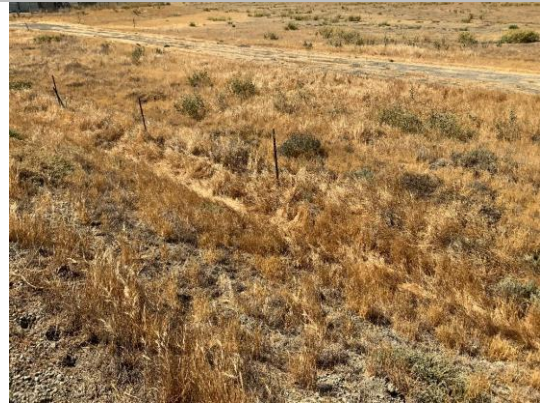
Photo 3 of 3 : UCIP_FA_2024_84929_102959.jpg

LS view: Slope from the crown, no pipe visible.

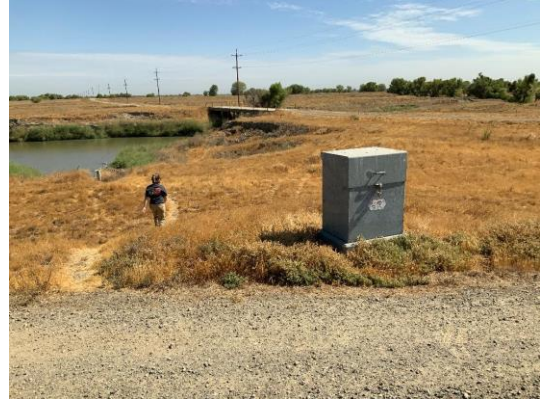
Photo 1 of 1 : UCIP_FA_2024_71100_102967.jpg

Comment Code						
Inspector Comment						
DS_ID:19824 FS_ID:71100 EP_NO: 6965 Repair Type: Non-Urgent EVAL Issue: 10, Unauthorized Modification or Non-Compliant Permit Crossing Status: Indicator Found UCIP Comments: 07/27/2021 The record remains Non-Urgent. Crossing appears to be modified, there is no WS pump or platform. No sign of pipe visible on LS, unless pipe goes to large plant facility off the toe. Confirm with owner on the alignment and status of pipe. The UCIP inspection was completed with GEI staff, P. Espinoza. (H. Dunn ? GEI) 04/18/2014 Description of structure does not match. Need to contact owner. Current description includes concrete platform, trash screen, and gage reading on waterward side. Metal box located on waterward shoulder. Large plant facility locate on landward side. (O. Magana - DWR UCIP) FIELD_STRUCT_DESC: 16-inch coated steel irrigation discharge pipe through the levee, 7.4 feet below the crown. Corrugated metal (CM) cutoff wall around the pipe at the center of the levee. Pump on the waterside (WS) with a timber platform on the berm for support. Siphon breaker on the apex of the pipe on the landside (LS) shoulder. Pipe exposed on both slopes. (20-inch irrigation pipe authorized under Permit No. 6965, 1971 - Scarborough, Robinson, and Associates). [Additional Reference(s): DWR Levee Log, 2002, (HLM 3.44)]. FS Date: 7/27/2021

WS view: Toe from crown.

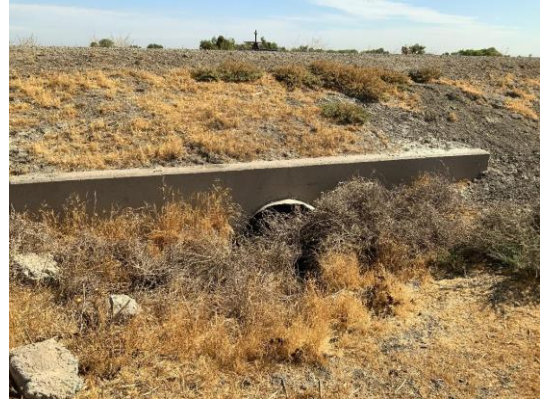
Photo 1 of 3 : UCIP_FA_2024_84512_102973.jpg

Comment Code					
Inspector Comment					
DS_ID:19825 FS_ID:84512 EP_NO: N/A Repair Type: Non-Urgent EVAL Issue: 4b, Safety Issue Crossing Status: Found UCIP Comments: 07/27/2021 The record remains Non-Urgent. DWR DMP internal inspection has found pipe integrity issues. LOF of crossing is between 4.1 and 5. Crossing will be monitored until funding becomes available for rehabilitation. WS riser has broken cover, creating a safety hazard. Limited inspection due to dense tumbleweeds over LS inlet, recommend removal. No permit was found authorizing this encroachment. CVFPB will need to review crossing to determine owner. The UCIP inspection was completed with GEI staff, P. Espinoza. (H. Dunn ? GEI)04/18/2014 Sediment buildup inside pipe visible from landward side. Excess soil is also present on landward toe partially blocking concrete headwall and inlet. Recommend removing soil from landward toe and clear buildup inside. (O. Magana - DWR UCIP) FIELD_STRUCT_DESC: 36-inch corrugated metal gravity drainage pipe (CMP) through the levee, 6.8 feet below the crown. Slide gate in a 48-inch CMP riser unit on the waterside (WS) slope. Concrete headwall on each end. [Additional Reference(s): DWR Levee Log, 2002, (HLM 3.54). USACE San Joaquin O&M Manual, Unit No. 601, Part No. 1, 1967, Amended in 1978, Revised 20 June 1985, (HLM 3.54). DWR As-Built Drawing No. 61-01, Sheet No. 47, Station 187+01, 7 March 1961]. FS Date: 7/27/2021

LS view: Headwall and slope from toe.

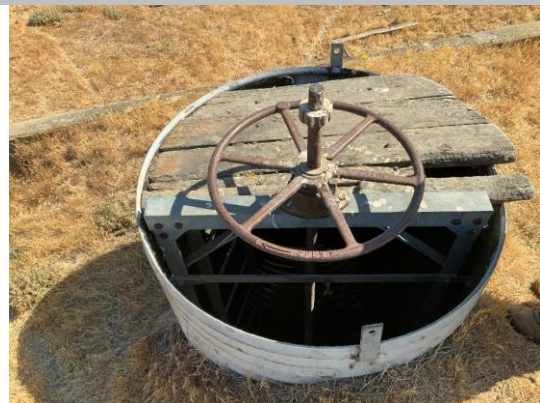
Photo 2 of 3 : UCIP_FA_2024_84512_102977.jpg

WS view: Closeup of the riser on the slope with missing cover.

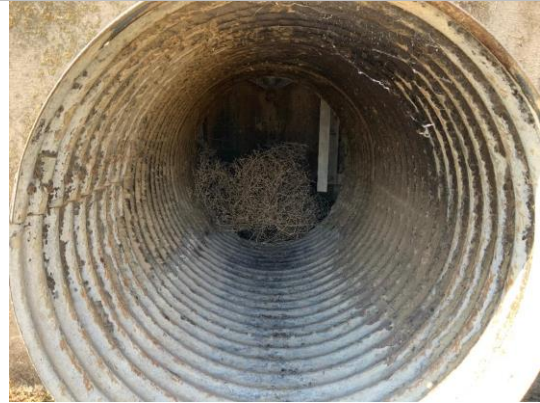
Photo 3 of 3 : UCIP_FA_2024_84512_102971.jpg

WS view: Inside of pipe outlet at toe.

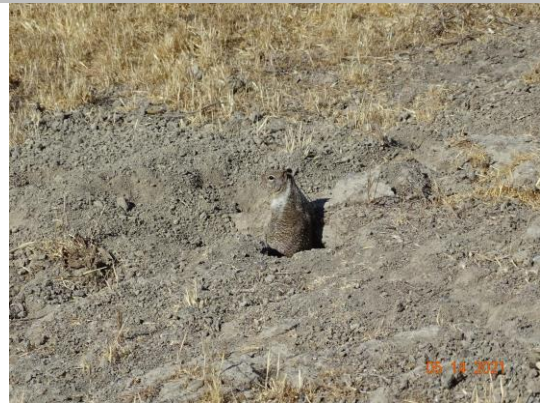
Photo 1 of 1 : FA_2024_NA0010_124_67_20240828_00015.jpg

LM Start	3.49	Rating **	M	Issue No.	67
LM End	3.49	Issue Type +	Ma	Location *	LS
Category	Earthen Levee			GPS Latitude/Longitude	
				Start	End
Item	Animal Control			37.251602°	37.251602°
				-120.778118°	-120.778118°
DWR ID	DWR_NA0010_06_f_2017_67				
Comment Code					
A1 : Exterminate rodents and backfill and compact or grout burrows.					
Inspector Comment

View of active rodent and burrow on the landside slope. (Spring 2021)

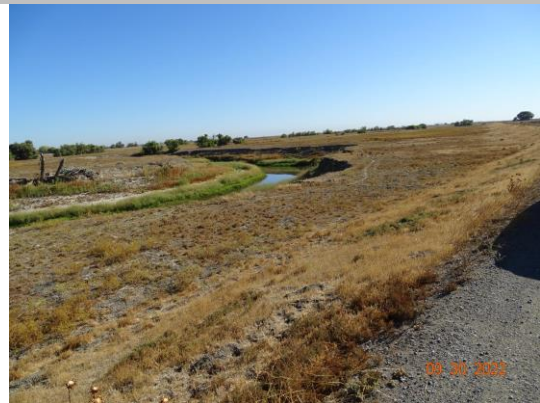
Photo 1 of 1 : FA_2024_NA0010_124_96_20240828_00032.jpg

LM Start	3.62	Rating **	A/W	Issue No.	96
LM End	3.67	Issue Type +	Ma	Location *	WS
Category	Earthen Levee			GPS Latitude/Longitude	
				Start	End
Item	Erosion / Bank Caving			37.251226°	37.251140°
				-120.775774°	-120.774900°
DWR ID	DWR_NA0010_06_f_2022_96				
Comment Code					
E1 : Note and monitor erosion site.					
Inspector Comment					
Erosion is approximately 30 ft from levee toe, 18 ft in height, and 150 ft in length.

View of erosion on the waterside berm. (Fall 2022)

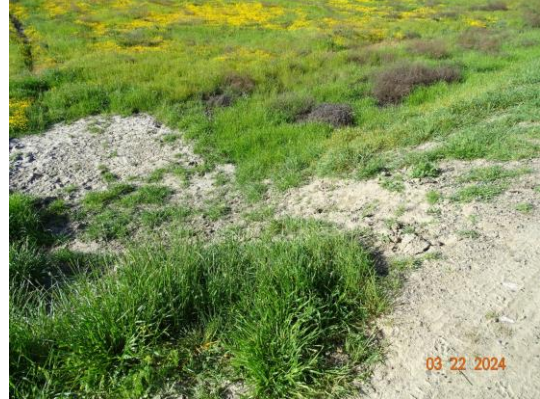
Photo 1 of 1 : FA_2024_NA0010_124_122_20240828_00047.jpg

LM Start	3.68	Rating **	A/W	Issue No.	122
LM End	3.68	Issue Type +	Ma	Location *	LS
Category	Earthen Levee			GPS Latitude/Longitude	
				Start	End
Item	Erosion / Livestock			37.251161 °	37.251161 °
				-120.774659 °	-120.774659 °
DWR ID	DWR_NA0010_06_f _ 2021_122				
Comment Code					
E4 : Repair the levee slope damaged by livestock and prevent large animal access.					
Inspector Comment

View of slope damage due to animal traffic. (Spring 2024)

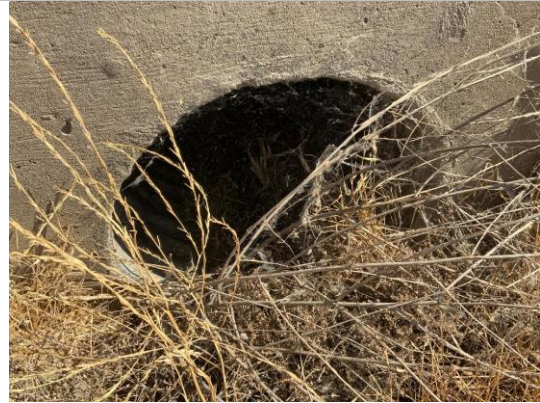
Photo 1 of 2 : UCIP_FA_2024_71102_102984.jpg

Comment Code						
Inspector Comment						
DS_ID:19826 FS_ID:71102 EP_NO: N/A Repair Type: Non-Urgent EVAL Issue: Crossing Status: Found UCIP Comments: 09/18/2023 Pipe was CIPP lined. DMP internal video inspection has found none or minor pipe defects. Recommend next video inspection in 5 years. (O. Yakimov - DWR UCIP) 07/27/2021 The record remains Non-Urgent. DWR DMP internal inspection has found pipe integrity issues. LOF of crossing is between 4.1 and 5. Crossing will be monitored until funding becomes available for rehabilitation. Limited inspection of LS pipe inlet due to vegetation covering it, recommend removal. Exterior liner of WS flapgate is significantly chipping off. No permit was found authorizing this encroachment. CVFPB will need to review crossing to determine owner. The UCIP inspection was completed with GEI staff, P. Espinoza. (H. Dunn ? GEI)04/18/2014 Sediment buildup inside crossing and is visible from landward side. Recommend clearing sediment buildup inside pipe and check wall integrity to determine condition. (O. Magana - DWR UCIP) FIELD_STRUCT_DESC: 24-inch CIPP-lined corrugated metal gravity drainage pipe (CMP) through the levee, 7.0 feet below the crown. Flap gate on the waterside (WS) end. Concrete headwall on each end. [Additional Reference(s): DWR Levee Log, 2002, (HLM 3.78). USACE San Joaquin O&M Manual, Unit No. 601, Part No. 1, 1967, Amended in 1978, Revised 20 June 1985, (HLM 3.77). DWR As-Built Specification No. 61-01, Sheet No. 47, 7 March 1961, (HLM 3.77)]. FS Date: 7/27/2021

LS view: Closeup of pipe inlet at toe with vegetation cover.

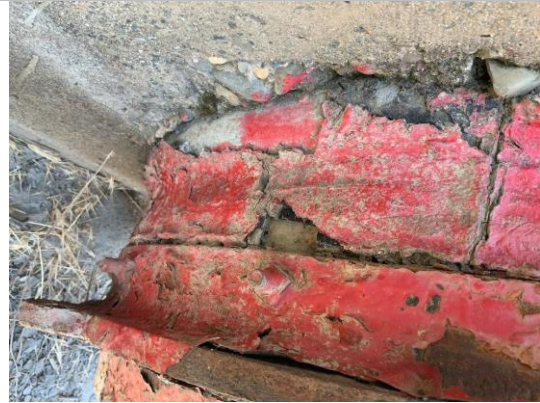
Photo 2 of 2 : UCIP_FA_2024_71102_102980.jpg

WS view: Closeup of liner deterioration on flapgate at toe.

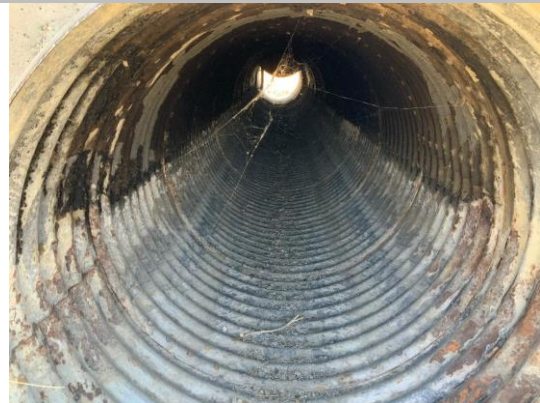
Photo 1 of 2 : UCIP_FA_2024_84930_102997.jpg

DS_ID:19827
 FS_ID:84930
 EP_NO: N/A
 Repair Type: Non-Urgent
 EVAL Issue: 5, Pipe Damage
 Crossing Status: Found
 UCIP Comments: 07/27/2021 The record remains Non-Urgent. DWR DMP internal inspection has found pipe integrity issues. LOF of crossing is between 4.1 and 5. Crossing will be monitored until funding becomes available for rehabilitation. No permit was found authorizing this encroachment. CVFPB will need to review crossing to determine owner. The UCIP inspection was completed with GEI staff, P. Espinoza. (H. Dunn ? GEI)04/18/2014 Sediment buildup inside crossing and is visible from landward side. Recommend clearing sediment buildup inside pipe and check wall integrity to determine condition. (O. Magana - DWR UCIP)
 FIELD_STRUCT_DESC: 36-inch corrugated metal gravity drainage pipe (CMP) through the levee, 6.7 feet below the crown. Slide gate in a 48-inch CMP riser unit on the waterside (WS) slope. [Additional Reference(s): DWR Levee Log, 2002, (HLM 3.98). USACE San Joaquin O&M Manual, Unit No. 601, Part No. 1, 1967, Amended in 1978, Revised 20 June 1985, (HLM 3.97). DWR As-Built Specification No. 61-01, Sheet No. 47, 7 March 1961, (HLM 3.97)].

LS view: Inside pipe inlet at toe.

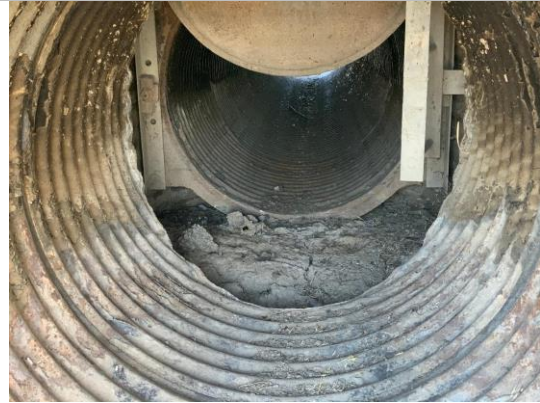
Photo 2 of 2 : UCIP_FA_2024_84930_102993.jpg

WS view: Inside pipe outlet at toe.

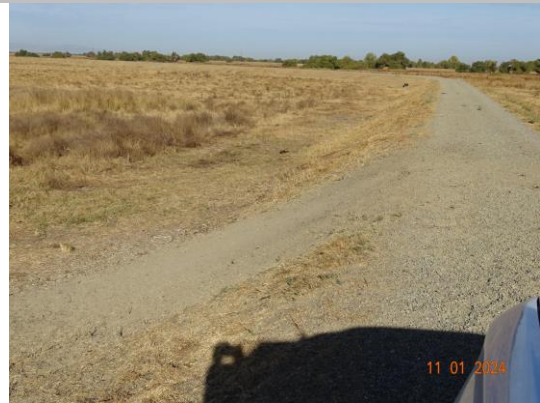
Photo 1 of 1 : FA_2024_NA0010_124_99_20241105_00148.jpg

LM Start	3.96	Rating **	A/W	Issue No.	99
LM End	3.96	Issue Type +	Ma	Location *	LS
Category	Earthen Levee			GPS Latitude/Longitude	
				Start	End
Item	Erosion / Livestock			37.249957 °	37.249957 °
				-120.770325 °	-120.770325 °
DWR ID	DWR_NA0010_06_f_2024_99				
Comment Code					
E4 : Repair the levee slope damaged by livestock and prevent large animal access.					
Inspector Comment

Erosion from livestock traffic on the landside slope. (Fall 2024)

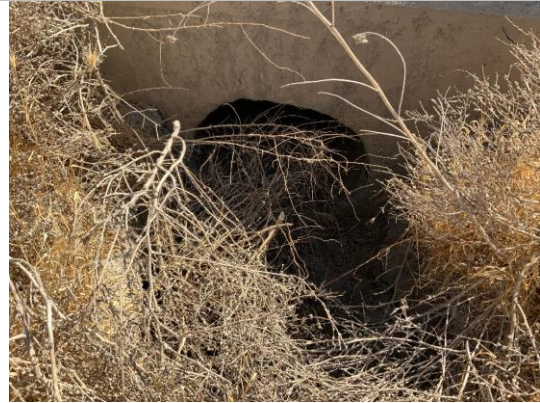
Photo 1 of 1 : UCIP_FA_2024_71104_103008.jpg

Comment Code						
Inspector Comment						
DS_ID:19828 FS_ID:71104 EP_NO: N/A Repair Type: Non-Urgent EVAL Issue: 5, Pipe Damage Crossing Status: Found UCIP Comments: 09/25/2024 DMP internal video inspection has found moderate pipe defects. Crossing will be monitored until funding becomes available for rehabilitation. (O. Yakimov - DWR UCIP) 07/27/2021 The record remains Non-Urgent. Limited inspection due to LS pipe inlet being covered by dense tumbleweeds, recommend removal. No permit was found authorizing this encroachment. CVFPB will need to review crossing to determine owner. The UCIP inspection was completed with GEI staff, P. Espinoza. (H. Dunn-? GEI) 04/18/2014 Dense vegetation limits the inspector's visibility to identify signs of pipe condition on landward toe--headwall blocked by dense vegetation. Recommend removing vegetation from landward toe. (O. Magana - DWR UCIP) FIELD_STRUCT_DESC: 24-inch corrugated metal gravity drainage pipe (CMP) through the levee, 10.8 feet below the crown. Flap gate on the waterside (WS) end. Concrete headwall on each end. [Additional Reference(s): DWR Levee Log, 2002, (HLM 4.17). USACE San Joaquin O&M Manual, Unit No. 601, Part No. 1, 1967, Amended in 1978, Revised 20 June 1985, (HLM 4.17). DWR As-Built Specification No. 61-01, Sheet No. 48, 7 March 1961, (HLM 4.17)]. FS Date: 7/27/2021

LS view: Closeup of pipe inlet at toe covered by tumbleweeds.

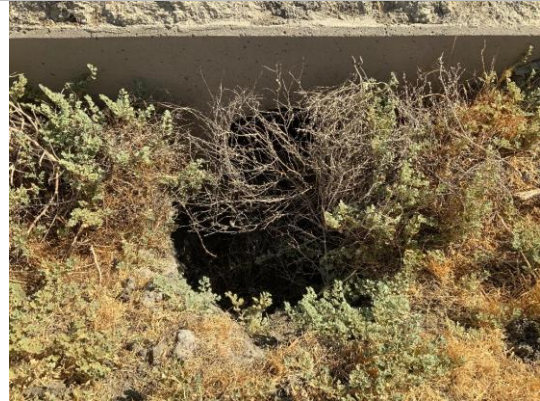
Photo 1 of 1 : UCIP_FA_2024_71105_103022.jpg

Comment Code					
Inspector Comment					
DS_ID:19829 FS_ID:71105 EP_NO: N/A Repair Type: Non-Urgent EVAL Issue: Crossing Status: Found UCIP Comments: 09/18/2023 Pipe was CIPP lined. DMP internal video inspection has found none or minor pipe defects. Recommend next video inspection in 5 years. (O. Yakimov - DWR UCIP) 07/27/2021 The record remains Non-Urgent. DWR DMP internal inspection has found pipe integrity issues. LOF of crossing is between 4.1 and 5. Crossing will be monitored until funding becomes available for rehabilitation. Limited inspection due to LS pipe inlet having some vegetation overgrowth over it, recommend removal. No permit was found authorizing this encroachment. CVFPB will need to review crossing to determine owner. The UCIP inspection was completed with GEI staff, P. Espinoza. (H. Dunn ? GEI)04/18/2014 Dense vegetation limits the inspector's visibility to identify signs of pipe condition on landward toe--headwall blocked by dense vegetation. Recommend removing vegetation from landward toe. (O. Magana - DWR UCIP) FIELD_STRUCT_DESC: 24-inch CIPP-lined corrugated metal gravity drainage pipe (CMP) through the levee, 11.3 feet below the crown. Flap gate on the waterside (WS) end. Concrete headwall on each end. [Additional Reference(s): DWR Levee Log, 2002, (HLM 4.43). USACE San Joaquin O&M Manual, Unit No. 601, Part No. 1, 1967, Amended in 1978, Revised 20 June 1985, (HLM 4.41). DWR As-Built Specification No. 61-01, Sheet No. 48, 7 March 1961, (HLM 4.41)]. FS Date: 7/27/2021

LS view: Closeup of pipe inlet at toe covered by vegetation.

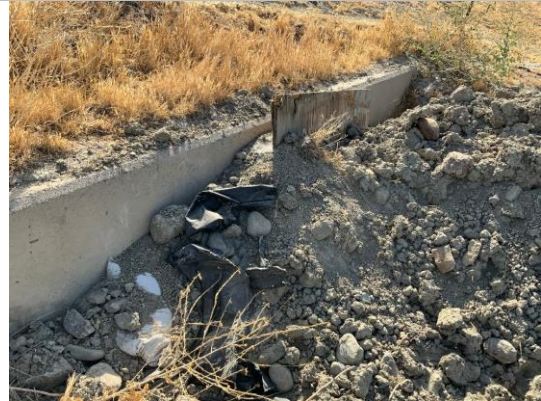
Photo 1 of 2 : UCIP_FA_2024_71106_103032.jpg

Comment Code					
Inspector Comment					
DS_ID:19830 FS_ID:71106 EP_NO: N/A Repair Type: Non-Urgent EVAL Issue: 4b, Safety Issue Crossing Status: Found UCIP Comments: 09/25/2024 DMP internal video inspection has found moderate pipe defects. Crossing will be monitored until funding becomes available for rehabilitation. (O. Yakimov - DWR UCIP) 07/27/2021 The record remains Non-Urgent. WS riser has no cover, causing safety hazard. Limited inspection due to LS pipe inlet completely buried within large dirt pile, recommend clearing out. No permit was found authorizing this encroachment. CVFPB will need to review crossing to determine owner. The UCIP inspection was completed with GEI staff, P. Espinoza. (H. Dunn ? GEI)04/18/2014 Sediment buildup inside crossing visible from landward side. Recommend clearing sediment buildup inside pipe and check wall integrity to determine condition. (O. Magana - DWR UCIP) FIELD_STRUCT_DESC: 36-inch corrugated metal gravity drainage pipe (CMP) through the levee, 6.9 feet below the crown. Slide gate in a 48-inch CMP riser unit on the waterside (WS) slope. Concrete headwall on the landside (LS) end. Concrete saddle and apron on the WS end. [Additional Reference(s): DWR Levee Log, 2002, (HLM 4.69). USACE San Joaquin O&M Manual, Unit No. 601, Part No. 1, 1967, Amended in 1978, Revised 20 June 1985, (HLM 4.70). DWR As-Built Specification No. 61-01, Sheet No. 48, 7 March 1961, (HLM 4.70)]. FS Date: 7/27/2021

LS view: Pile of dirt completely covering pipe inlet at toe.

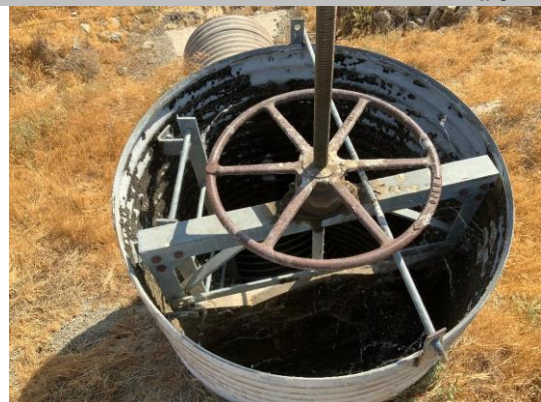
Photo 2 of 2 : UCIP_FA_2024_71106_103027.jpg

WS view: Closeup of riser without lid on slope.

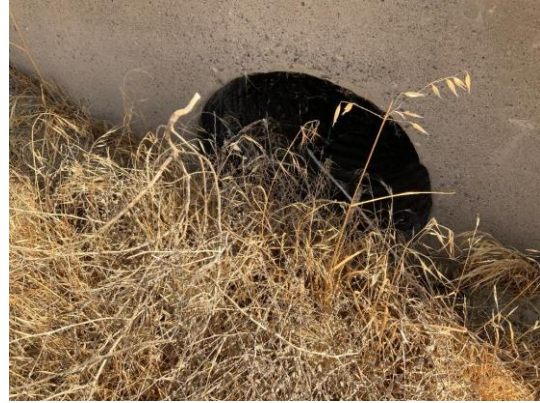
Photo 1 of 1 : UCIP_FA_2024_84971_103040.jpg

DS_ID:19831
FS_ID:84971
EP_NO: N/A
Repair Type: No Action Needed
EVAL Issue:
Crossing Status: Found
UCIP Comments: 10/07/2024 Record updated from Non-Urgent to No Action Needed. Removed code 12b since pipe is drainage and record source is Levee Log and O&M. Removed code 11 since vegetation is not maintenance of the pipe. (M. Thao - DWR UCIP 12/20/2022)
Record updated from Urgent to Non-Urgent. Pipe has been CIPP lined. LOF of crossing is less or equal to 4. Recommend next video inspection in 5 years. (O.Yakimov - DWR UCIP 7/27/2021 The record has been upgraded from Non-Urgent to Urgent. DWR DMP internal inspection has found pipe integrity issues. LOF of crossing is greater than or equal to 5. Crossing will be monitored until funding becomes available to address the issues. Vegetation over LS pipe inlet, recommend removal. No permit was found authorizing this encroachment. CVFPB will need to review crossing to determine owner. The UCIP inspection was completed with GEI staff, P. Espinoza. (H. Dunn ? GEI 4/18/2014 Need to contact owner. Recommend removing tall grass on landward toe to determine condition of crossing from landward side. (O. Magana - DWR UCIP)

LS view: Closeup of pipe inlet at toe with minor vegetation growth.

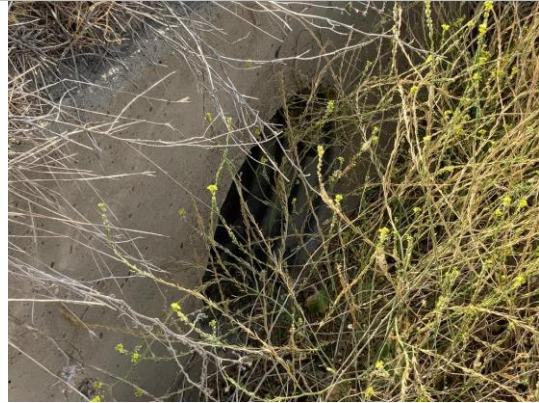
Photo 1 of 1 : UCIP_FA_2024_71108_103049.jpg

Comment Code						
Inspector Comment						
DS_ID:19862 FS_ID:71108 EP_NO: N/A Repair Type: Non-Urgent EVAL Issue: Crossing Status: Found UCIP Comments: 09/18/2023 Pipe was CIPP lined. DMP internal video inspection has found none or minor pipe defects. Recommend next video inspection in 5 years. (O. Yakimov - DWR UCIP) 07/27/2021 The record remains Non-Urgent. DWR DMP internal inspection has found pipe integrity issues. LOF of crossing is between 4.1 and 5. Crossing will be monitored until funding becomes available for rehabilitation. Limited inspection due to dense vegetation over LS pipe inlet, recommend removal. No permit was found authorizing this encroachment. CVFPB will need to review crossing to determine owner. The UCIP inspection was completed with GEI staff, P. Espinoza. (H. Dunn ? GEI)04/18/2014 Dense vegetation limits the inspector's visibility to identify signs of pipe failure (leaks) along the waterward slope. Recommend removing vegetation along waterward slope to conduct proper inspection of structure. Also recommend removing dense vegetation blocking landward headwall. (O. Magana - DWR UCIP) FIELD_STRUCT_DESC: 24-inch CIPP-lined corrugated metal gravity drainage pipe (CMP) through the levee, 10.8 feet below the crown. Flap gate on the waterside (WS) end. Concrete headwall on each end. [Additional Reference(s): DWR Levee Log, 2002, (HLM 4.95). USACE San Joaquin O&M Manual, Unit No. 601, Part No. 1, 1967, Amended in 1978, Revised 20 June 1985, (HLM 4.94). DWR As-Built Specification No. 61-01, Sheet No. 48, 7 March 1961, (HLM 4.94)]. FS Date: 7/27/2021

LS view: Closeup of pipe inlet at toe covered by vegetation.

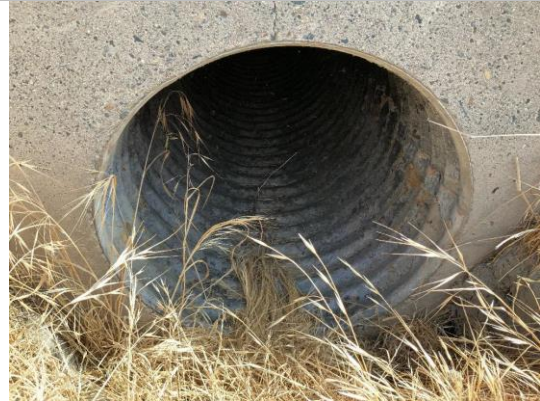
Photo 1 of 2 : UCIP_FA_2024_71109_103070.jpg

Comment Code						
Inspector Comment						
DS_ID:19863 FS_ID:71109 EP_NO: N/A Repair Type: No Action Needed EVAL Issue: Crossing Status: Found UCIP Comments: 09/18/2023 Record updated from Non-Urgent to No Action Needed. Pipe was CIPP lined. DMP internal video inspection has found none or minor pipe defects. Recommend next video inspection in 5 years. (O. Yakimov - DWR UCIP) 07/27/2021 The record remains Non-Urgent. DWR DMP internal inspection has found pipe integrity issues. LOF of crossing is greater than or equal to 4.1 and less than 5. Crossing will be monitored until funding becomes available for rehabilitation. No permit was found authorizing this encroachment. CVFPB will need to review crossing to determine owner. The UCIP inspection was completed with GEI staff, P. Espinoza. (H. Dunn ? GEI)04/18/2014 Clear vegetation from waterward slope and landward headwall. (O. Magana - DWR UCIP) FIELD_STRUCT_DESC: 24-inch CIPP-lined corrugated metal gravity drainage pipe (CMP) through the levee, 10.9 feet below the crown. Flap gate on the waterside (WS) end. Concrete headwall on each end. [Additional Reference(s): DWR Levee Log, 2002, (HLM 5.35). USACE San Joaquin O&M Manual, Unit No. 601, Part No. 1, 1967, Amended in 1978, Revised 20 June 1985, (HLM 5.34). DWR As-Built Specification No. 61-01, Sheet No. 48, 7 March 1961, (HLM 5.34)]. FS Date: 7/27/2021

LS view: Closeup of pipe inlet at toe.

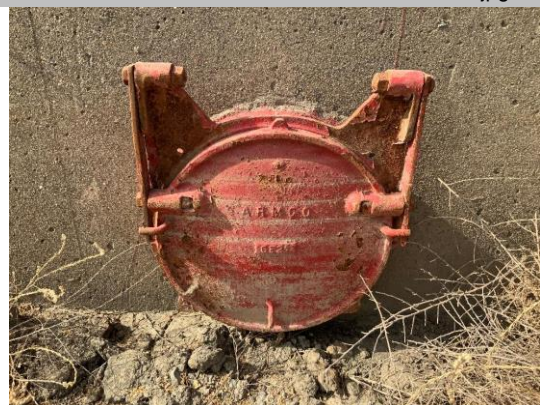
Photo 2 of 2 : UCIP_FA_2024_71109_103066.jpg

WS view: Closeup of flapgate at toe.

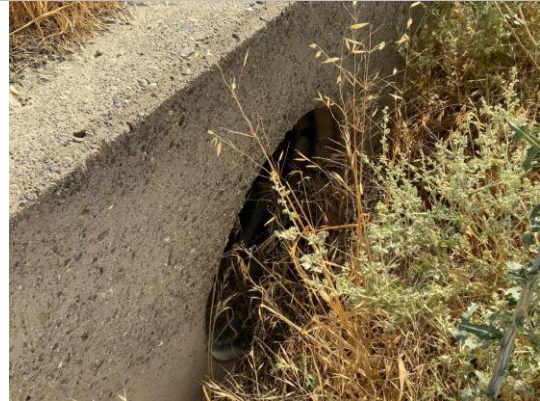
Photo 1 of 1 : UCIP_FA_2024_71110_103078.jpg

Comment Code						
Inspector Comment						
DS_ID:19864 FS_ID:71110 EP_NO: N/A Repair Type: Non-Urgent EVAL Issue: 11, Maintenance Compliance Issue Crossing Status: Found UCIP Comments: 07/27/2021 The record remains Non-Urgent. DWR DMP internal inspection has not found pipe integrity issues. LOF of crossing is less or equal to 4.0. Recommend next video inspection in 5 years. Limited inspection due to vegetation over LS pipe inlet, recommend removal. No permit was found authorizing this encroachment. CVFPB will need to review crossing to determine owner. The UCIP inspection was completed with GEI staff, P. Espinoza. (H. Dunn ? GEI)04/18/2014 Dense vegetation limits the inspector's visibility to identify signs of pipe failure (leaks) along the waterward slope. Recommend removing vegetation along pipe alignment to conduct proper inspection of structure. Also recommend removing excess vegetation at landward headwall. (O. Magana - DWR UCIP) FIELD_STRUCT_DESC: 24-inch corrugated metal gravity drainage pipe (CMP) through the levee, 11.0 feet below the crown. Flap gate on the waterside (WS) end. Concrete headwall on each end. [Additional Reference(s): DWR Levee Log, 2002, (HLM 5.63). USACE San Joaquin O&M Manual, Unit No. 601, Part No. 1, 1967, Amended in 1978, Revised 20 June 1985, (HLM 5.63). DWR As-Built Specification No. 61-01, Sheet No. 49, 7 March 1961, (HLM 5.63)]. FS Date: 7/27/2021

LS view: Closeup of pipe inlet at toe with vegetation growth.

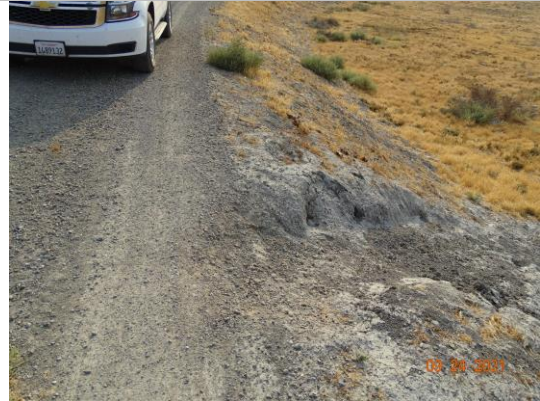
Photo 1 of 1 : FA_2024_NA0010_124_66_20240828_00014.jpg

LM Start	5.77	Rating **	A/W	Issue No.	66
LM End	5.77	Issue Type +	Ma	Location *	LS
Category	Earthen Levee			GPS Latitude/Longitude	
				Start	End
Item	Erosion / Livestock			37.238354 °	37.238354 °
				-120.742480 °	-120.742480 °
DWR ID	DWR_NA0010_06_f _ 2017_66				
Comment Code					
E4 : Repair the levee slope damaged by livestock and prevent large animal access.					
Inspector Comment					
Material has been place to repair the damage. Montior for settlement.

View of damage to landside slope from livestock traffic looking downstream. (Fall 2021)

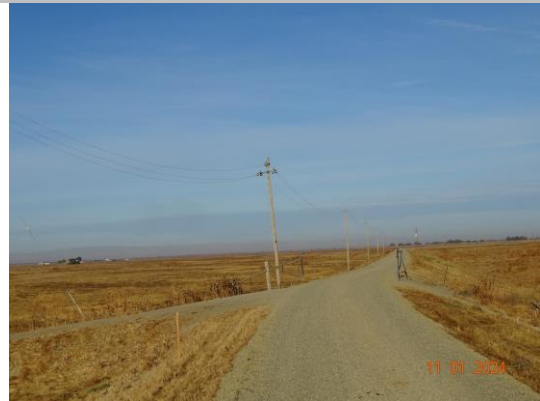
Photo 1 of 1 : FA_2024_NA0010_124_69_20241105_00149.jpg

LM Start	5.93	Rating **	M	Issue No.	69
LM End	7.09	Issue Type +	En	Location *	LS
Category	Earthen Levee			GPS Latitude/Longitude	
				Start	End
Item	Encroachments			37.236936 °	37.226800 °
				-120.740384 °	-120.724736 °
DWR ID	DWR_NA0010_06_s_2022_69				
Comment Code					
PO : Pole					
Inspector Comment					
There are several PG&E poles within this section at the landside toe and slope.

Looking downstream at PG&E poles on the landside slope and toe. (Fall 2024)

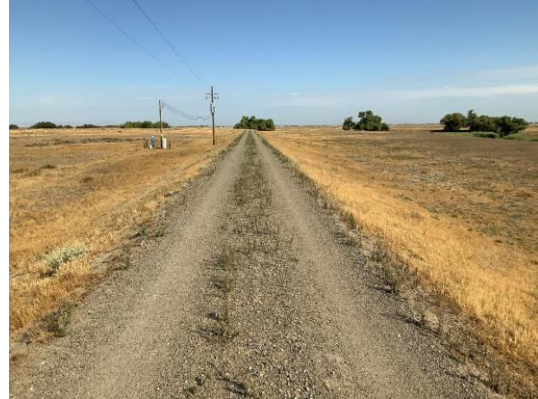
Photo 1 of 3 : UCIP_FA_2024_71111_103092.jpg

Comment Code						
Inspector Comment						
DS_ID:19865 FS_ID:71111 EP_NO: N/A Repair Type: Non-Urgent EVAL Issue: Crossing Status: Found UCIP Comments: 07/27/2021 The record has been upgraded from No Action Needed to Non-Urgent. No permit was found authorizing this encroachment. CVFPB will need to review crossing to determine owner. Crossing appears to be in good condition. Separate 10 inch plastic pipe inlet and flowmeter off the LS toe across this Crossing's inlet. The UCIP inspection was completed with GEI staff, P. Espinoza. (H. Dunn ? GEI) 7/19/2016 Site has been repaired on WS and LS (see photos below). (O. Magana - DWR UCIP) 5/26/2016 Erosion is undermining the WS headwall of drainage structure (photos of WS headwall provided by DWR Inspector R. Willoughby). Potential pipe failure at the outlet just behind headwall, recommend completing internal wall integrity of pipe length through levee to determine extent of damage to pipe. (O. Magana - DWR UCIP) 4/18/2014 Need to contact owner. Sediment buildup in pipe visible on landside--recommend clearing. (O. Magana - DWR UCIP) FIELD_STRUCT_DESC: 24-inch corrugated metal gravity drainage pipe (CMP) through the levee, 9.0 feet below the crown. Flap gate on the waterside (WS) end. Concrete headwall on each end. [Additional Reference(s): DWR Levee Log, 2002, (HLM 6.06). USACE San Joaquin O&M Manual, Unit No. 601, Part No. 1, 1967, Amended in 1978, Revised 20 June 1985, (HLM 6.06). DWR As-Built Specification No. 61-01, Sheet No. 49, 7 March 1961, (HLM 6.06)]. FS Date: 7/27/2021

Levee crown.

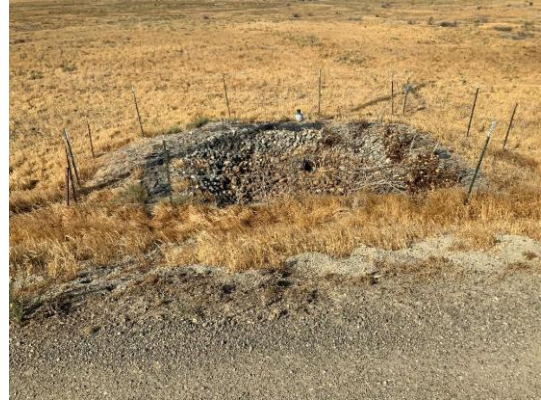
Photo 2 of 3 : UCIP_FA_2024_71111_103093.jpg

LS view: Toe from crown.

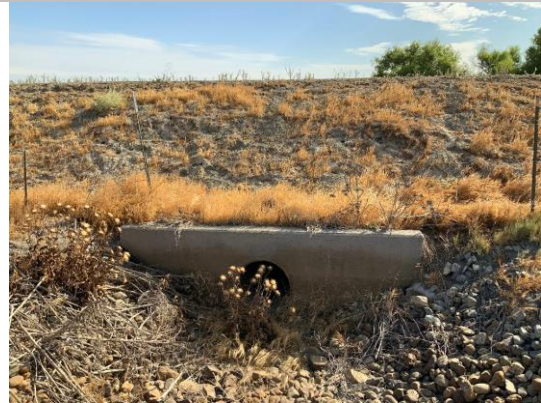
Photo 3 of 3 : UCIP_FA_2024_71111_103094.jpg

LS toe: Headwall and slope from toe.

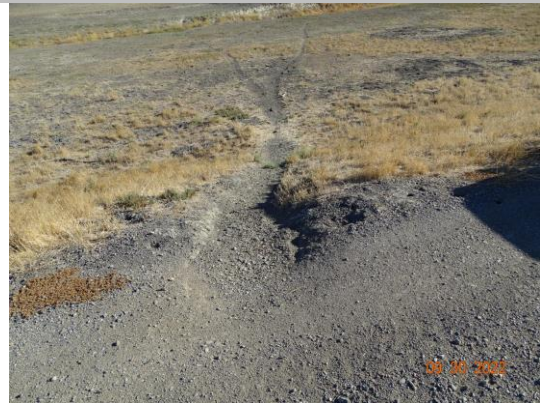
Photo 1 of 1 : FA_2024_NA0010_124_85_20240828_00025.jpg

LM Start	6.09	Rating **	A/W	Issue No.	85
LM End	6.09	Issue Type +	Ma	Location *	WS
Category	Earthen Levee			GPS Latitude/Longitude	
				Start	End
Item	Erosion / Livestock			37.235572 °	37.235572 °
				-120.738002 °	-120.738002 °
DWR ID	DWR_NA0010_06_f _ 2018_85				
Comment Code					
E4 : Repair the levee slope damaged by livestock and prevent large animal access.					
Inspector Comment					
Livestock damage to slope and shoulder of levee.

View of livestock damage on waterside slope. (Fall 2022)

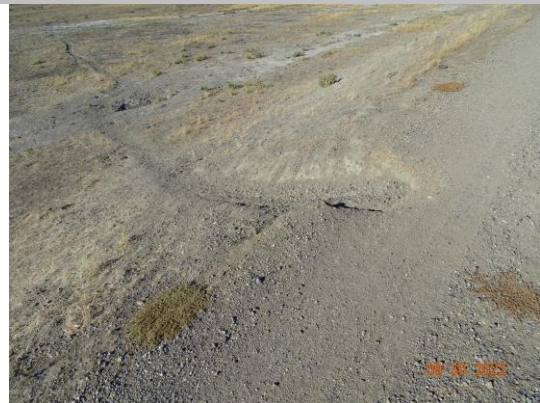
Photo 1 of 1 : FA_2024_NA0010_124_84_20240828_00024.jpg

LM Start	6.10	Rating **	A/W	Issue No.	84
LM End	6.10	Issue Type +	Ma	Location *	LS
Category	Earthen Levee			GPS Latitude/Longitude	
				Start	End
Item	Erosion / Livestock			37.235570°	37.235570°
				-120.737998°	-120.737998°
DWR ID	DWR_NA0010_06_f_2018_84				
Comment Code					
E4 : Repair the levee slope damaged by livestock and prevent large animal access.					
Inspector Comment					
Material has been placed to repair the slope damage. Monitor for settlement.

Erosion to slope and into crown from livestock. (Fall 2022)

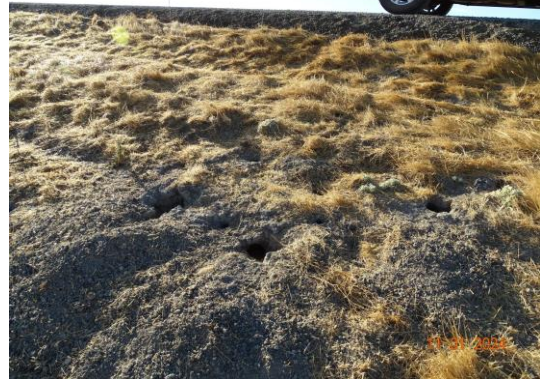
Photo 1 of 1 : FA_2024_NA0010_124_89_20241105_00150.jpg

LM Start	6.20	Rating **	M	Issue No.	89
LM End	6.20	Issue Type +	Ma	Location *	WS
Category	Earthen Levee			GPS Latitude/Longitude	
				Start	End
Item	Animal Control			37.235139 °	37.235139 °
				-120.736113 °	-120.736113 °
DWR ID	DWR_NA0010_06_f_2024_89				
Comment Code					
A3 : No rodents visible, but rodent burrows visible; need to backfill and compact or grout burrows.					
Inspector Comment

View of rodent holes on the waterside slope. (Fall 2024)

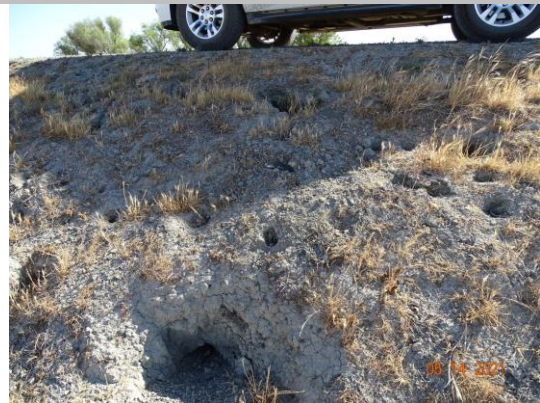
Photo 1 of 1 : FA_2024_NA0010_124_90_20240828_00028.jpg

LM Start	6.63	Rating **	M	Issue No.	90
LM End	6.63	Issue Type +	Ma	Location *	LS
Category	Earthen Levee			GPS Latitude/Longitude	
				Start	End
Item	Animal Control			37.231384 °	37.231384 °
				-120.730297 °	-120.730297 °
DWR ID	DWR_NA0010_06_s_2021_90				
Comment Code					
A3 : No rodents visible, but rodent burrows visible; need to backfill and compact or grout burrows.					
Inspector Comment

Looking at multiple rodent holes in the landside slope. (Spring 2021)

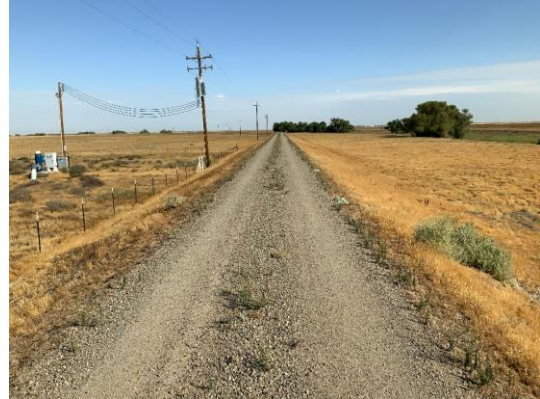
Photo 1 of 3 : UCIP_FA_2024_84934_103109.jpg

Levee crown.

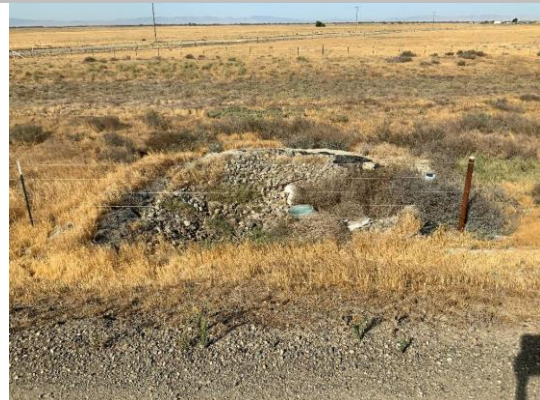
Photo 2 of 3 : UCIP_FA_2024_84934_103106.jpg

LS view: Toe from crown.

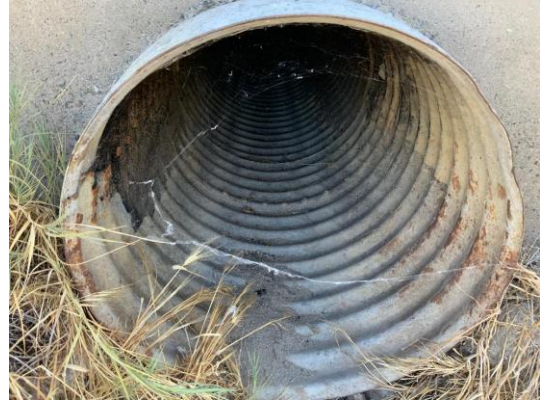
Photo 3 of 3 : UCIP_FA_2024_84934_103107.jpg

LS view: Closeup of pipe inlet at toe.

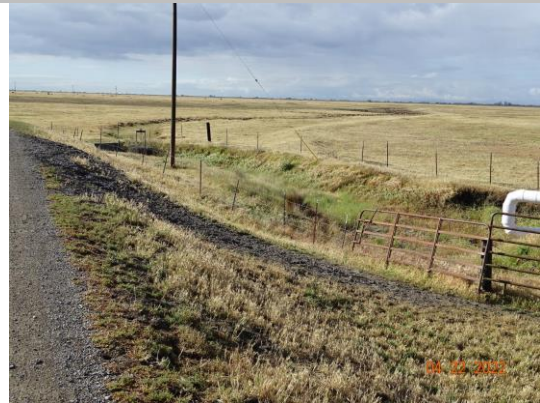
Photo 1 of 1 : FA_2024_NA0010_124_143_20240828_00061.jpg

LM Start	6.88	Rating **	M	Issue No.	143
LM End	6.88	Issue Type +	Ma	Location *	LS
Category	Earthen Levee			GPS Latitude/Longitude	
				Start	End
Item	Erosion / Livestock			37.228370 °	37.228370 °
				-120.728004 °	-120.728004 °
DWR ID	DWR_NA0010_06_s_2022_143				
Comment Code					
E4 : Repair the levee slope damaged by livestock and prevent large animal access.					
Inspector Comment

Levee damage on the landside slope from livestock activity. (Spring 2022)

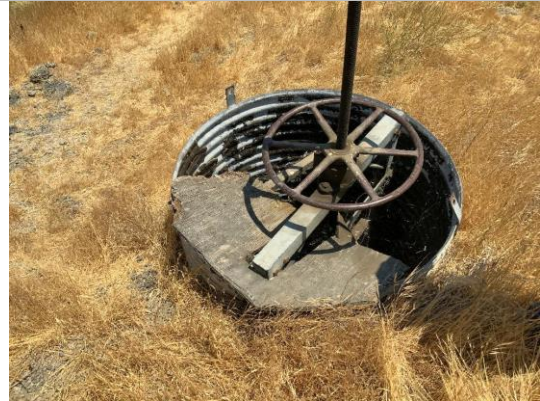
Photo 1 of 1 : UCIP_FA_2024_71113_101626.jpg

Comment Code						
Inspector Comment						
DS_ID:19867 FS_ID:71113 EP_NO: N/A Repair Type: Non-Urgent EVAL Issue: 4b, Safety Issue Crossing Status: Found UCIP Comments: 09/25/2024 DMP internal video inspection has found moderate pipe defects. Crossing will be monitored until funding becomes available for rehabilitation. (O. Yakimov - DWR UCIP) 07/13/2021 The record has been upgraded from No Action Needed to Non-Urgent. The cover on the WS riser is broken, causing a safety concern. There is another riser, pump, and pipe out closer to the channel on the WS but is not within 15 feet of the toe. No permit was found authorizing this encroachment. CVFPB will need to review crossing to determine owner. The UCIP inspection was completed with GEI staff, P. Espinoza. (H. Dunn ? GEI) FIELD_STRUCT_DESC: 36-inch corrugated metal gravity drainage pipe (CMP) through the levee, 10.7 feet below the crown. Slide gate in a 48-inch CMP riser unit on the waterside (WS) slope. Concrete headwall on the landside (LS) end. Concrete U-shaped headwall on the WS end. [Additional Reference(s): DWR Levee Log, 2002, (HLM 6.97). USACE San Joaquin O&M Manual, Unit No. 601, Part No. 1, 1967, Amended in 1978, Revised 20 June 1985, (HLM 6.97). DWR As-Built Specification No. 61-01, Sheet No. 50, 7 March 1961, (HLM 6.97)]. FS Date: 7/13/2021

WS view: Closeup of riser on slope with broken lid.

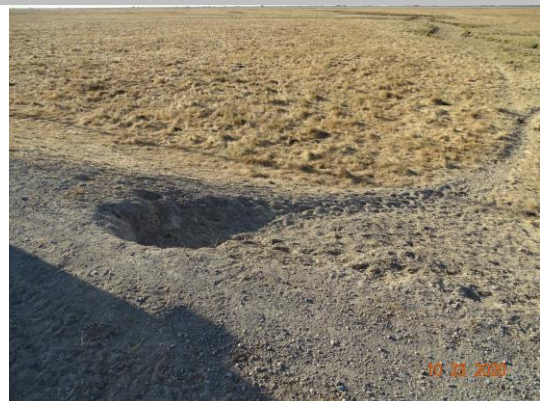
Photo 1 of 1 : FA_2024_NA0010_124_79_20240828_00022.jpg

LM Start	6.92	Rating **	A/W	Issue No.	79
LM End	6.92	Issue Type +	Ma	Location *	LS
Category	Earthen Levee			GPS Latitude/Longitude	
				Start	End
Item	Erosion / Livestock			37.228054 °	37.228054 °
				-120.727428 °	-120.727428 °
DWR ID	DWR_NA0010_06_f _ 2018_79				
Comment Code					
E4 : Repair the levee slope damaged by livestock and prevent large animal access.					
Inspector Comment					
Slope damage has been repaired with loose soil.

View down the landside slope of damage from livestock. (Fall 2020)

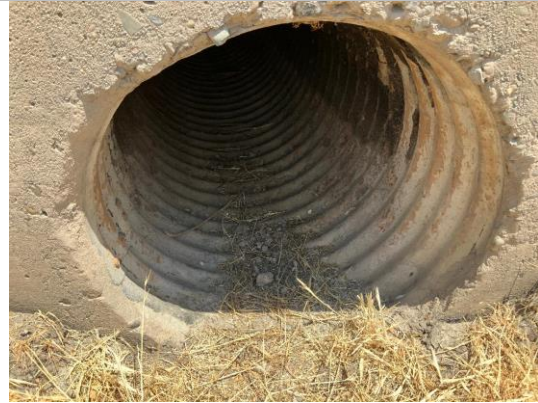
Photo 1 of 2 : UCIP_FA_2024_71114_101633.jpg

Comment Code						
Inspector Comment						
DS_ID:19868 FS_ID:71114 EP_NO: N/A Repair Type: No Action Needed EVAL Issue: Crossing Status: Found UCIP Comments: 09/18/2023 Record updated from Non-Urgent to No Action Needed. Pipe was CIPP lined. DMP internal video inspection has found none or minor pipe defects. Recommend next video inspection in 5 years. (O. Yakimov - DWR UCIP) 07/13/2021 Record is still Non-Urgent. DWR DMP internal inspection has found pipe integrity issues. LOF of crossing is between 4.1 and 5. Crossing will be monitored until funding becomes available for rehabilitation. No permit was found authorizing this encroachment. CVFPB will need to review crossing to determine owner. The UCIP inspection was completed with GEI staff, P. Espinoza. (H. Dunn ? GEI) 04/18/2014 Need to contact owner. Clear animal from waterward side. Some sediment buildup in pipe visible landward side--recommend clearing. (O. Magana - DWR UCIP) FIELD_STRUCT_DESC: 24-inch CIPP-lined corrugated metal gravity drainage pipe (CMP) through the levee, 10.6 feet below the crown. Flap gate on the waterside (WS) end. Concrete headwall on each end. [Additional Reference(s): DWR Levee Log, 2002, (HLM 7.29). USACE San Joaquin O&M Manual, Unit No. 601, Part No. 1, 1967, Amended in 1978, Revised 20 June 1985, (HLM 7.29). DWR As-Built Specification No. 61-01, Sheet No. 50, 7 March 1961, (HLM 7.29)]. FS Date: 7/13/2021

LS view: Closeup of pipe inlet at toe.

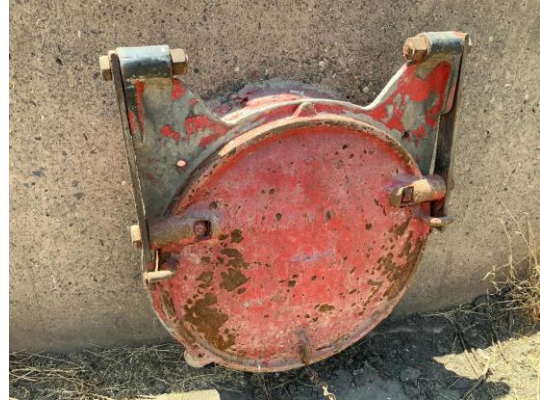
Photo 2 of 2 : UCIP_FA_2024_71114_101637.jpg

WS view: Closeup of flapgate at toe.

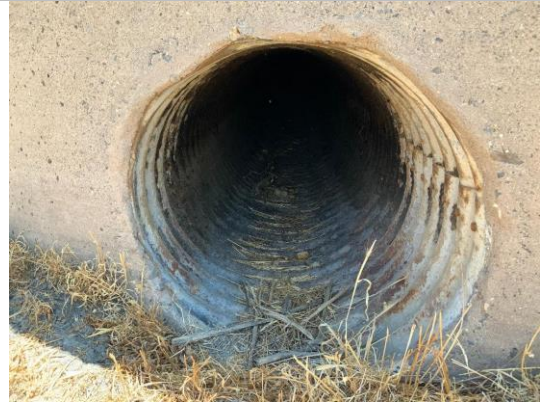
Photo 1 of 2 : UCIP_FA_2024_71115_101646.jpg

Comment Code						
Inspector Comment						
DS_ID:19869 FS_ID:71115 EP_NO: N/A Repair Type: No Action Needed EVAL Issue: Crossing Status: Found UCIP Comments: 09/18/2023 Record updated from Non-Urgent to No Action Needed. Pipe was CIPP lined. DMP internal video inspection has found none or minor pipe defects. Recommend next video inspection in 5 years. (O. Yakimov - DWR UCIP) 07/13/2021 Record remains Non-Urgent. DWR DMP internal inspection has found pipe integrity issues. LOF of crossing is greater than or equal to 4.1 and less than 5. Crossing will be monitored until funding becomes available for rehabilitation. No longer sediment buildup as mentioned in previous inspection. No permit was found authorizing this encroachment. CVFPB will need to review crossing to determine owner. The UCIP inspection was completed with GEI staff, P. Espinoza. (H. Dunn ? GEI)04/18/2014 Some sediment buildup in pipe visible on landward side--recommend clearing. (O. Magana - DWR UCIP) FIELD_STRUCT_DESC: 24-inch CIPP-lined corrugated metal gravity drainage pipe (CMP) through the levee, 11.8 feet below the crown. Flap gate on the waterside (WS) end. Concrete headwall on each end. Skewed crossing. [Additional Reference(s): DWR Levee Log, 2002, (HLM 7.74). USACE San Joaquin O&M Manual, Unit No. 601, Part No. 1, 1967, Amended in 1978, Revised 20 June 1985, (HLM 7.74). DWR As-Built Specification No. 61-01, Sheet No. 50, 7 March 1961, (HLM 7.74)]. FS Date: 7/13/2021

LS view: Closeup of pipe inlet at toe.

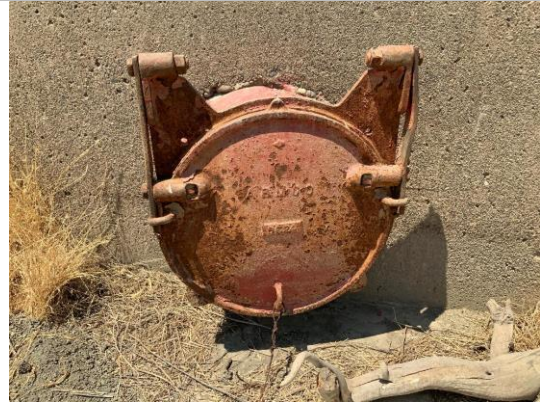
Photo 2 of 2 : UCIP_FA_2024_71115_101642.jpg

WS view: Closeup of flapgate at toe.

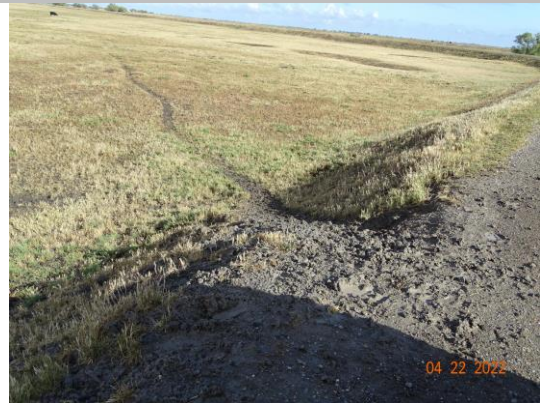
Photo 1 of 1 : FA_2024_NA0010_124_74_20240828_00020.jpg

LM Start	7.66	Rating **	A/W	Issue No.	74
LM End	7.66	Issue Type +	Ma	Location *	LS
Category	Earthen Levee			GPS Latitude/Longitude	
				Start	End
Item	Erosion / Livestock			37.222689 °	37.222689 °
				-120.716400 °	-120.716400 °
DWR ID	DWR_NA0010_06_f _ 2018_74				
Comment Code					
E4 : Repair the levee slope damaged by livestock and prevent large animal access.					
Inspector Comment					
Damage to levee slope from livestock access.

Slope damage from livestock. (Spring 2022)

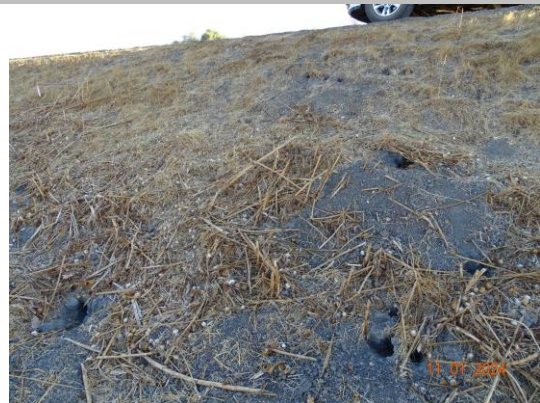
Photo 1 of 1 : FA_2024_NA0010_124_88_20241105_00151.jpg

LM Start	7.81	Rating **	M	Issue No.	88
LM End	7.81	Issue Type +	Ma	Location *	LS
Category	Earthen Levee			GPS Latitude/Longitude	
				Start	End
Item	Animal Control			37.220680 °	37.220680 °
				-120.715552 °	-120.715552 °
DWR ID	DWR_NA0010_06_f_2024_88				
Comment Code					
A3 : No rodents visible, but rodent burrows visible; need to backfill and compact or grout burrows.					
Inspector Comment					
Multiple rodent burrows between the landside ramp and this location.

View of multiple animal burrows on the landside slope. (Fall 2024)

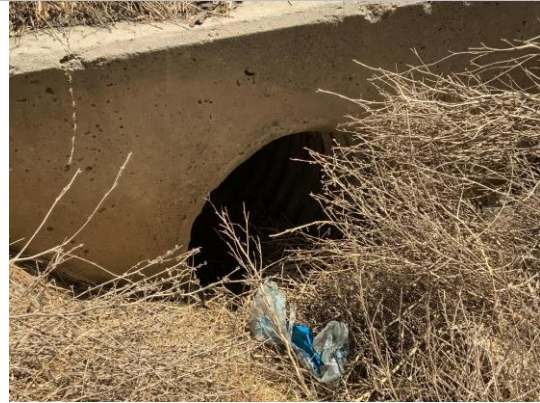
Photo 1 of 2 : UCIP_FA_2024_71116_102250.jpg

Comment Code						
Inspector Comment						
DS_ID:19870 FS_ID:71116 EP_NO: N/A Repair Type: No Action Needed EVAL Issue: Crossing Status: Found UCIP Comments: 09/18/2023 Record updated from Non-Urgent to No Action Needed. Pipe was CIPP lined. DMP internal video inspection has found none or minor pipe defects. Recommend next video inspection in 5 years. (O. Yakimov - DWR UCIP) 07/13/2021 Record remains Non-Urgent. DWR DMP internal inspection has found pipe integrity issues. LOF of crossing is greater than or equal to 4.1 and less than 5. Crossing will be monitored until funding becomes available for rehabilitation. Some vegetation buildup over LS pipe inlet and WS flapgate, recommend removal of vegetation on both ends. No permit was found authorizing this encroachment. CVFPB will need to review crossing to determine owner. The UCIP inspection was completed with GEI staff, P. Espinoza. (H. Dunn ? GEI)04/18/2014 Sediment buildup in pipe--recommend contacting owner to clear sediment. (O. Magana - DWR UCIP) FIELD_STRUCT_DESC: 24-inch CIPP-lined corrugated metal gravity drainage pipe (CMP) through the levee, 16.5 feet below the crown. Flap gate on the waterside (WS) end. Concrete headwall on each end. [Additional Reference(s): DWR Levee Log, 2002, (HLM 8.22). USACE San Joaquin O&M Manual, Unit No. 601, Part No. 1, 1967, Amended in 1978, Revised 20 June 1985, (HLM 8.21). DWR As-Built Specification No. 61-01, Sheet No. 51, 7 March 1961, (HLM 8.21)]. FS Date: 7/13/2021

LS view: Closeup of pipe inlet at toe. Some vegetation blocking.

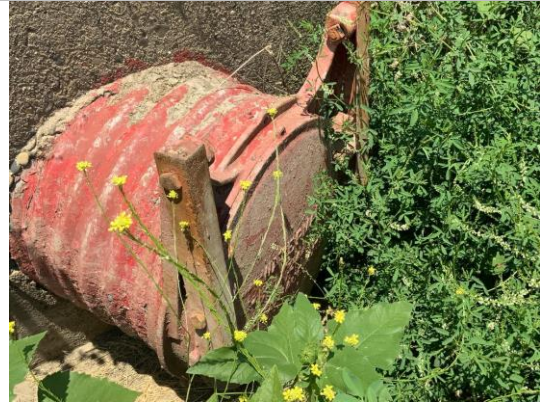
Photo 2 of 2 : UCIP_FA_2024_71116_102246.jpg

WS view: Closeup of flapgate at toe.

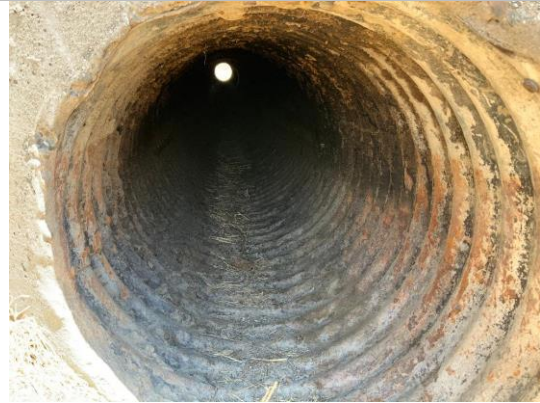
Photo 1 of 2 : UCIP_FA_2024_71117_102257.jpg

Comment Code						
Inspector Comment						
DS_ID:19871 FS_ID:71117 EP_NO: N/A Repair Type: No Action Needed EVAL Issue: Crossing Status: Found UCIP Comments: 09/18/2023 Record updated from Non-Urgent to No Action Needed. Pipe was CIPP lined. DMP internal video inspection has found none or minor pipe defects. Recommend next video inspection in 5 years. (O. Yakimov - DWR UCIP) 07/13/2021 Record remains Non-Urgent. DWR DMP internal inspection has found pipe integrity issues. LOF of crossing is between 4.1 and 5. Crossing will be monitored until funding becomes available for rehabilitation. Inside of LS pipe inlet is rusted but no visible holes or deterioration. No permit was found authorizing this encroachment. CVFPB will need to review crossing to determine owner. The UCIP inspection was completed with GEI staff, P. Espinoza. (H. Dunn ? GEI) 04/18/2014 Need to contact owner. Sediment buildup in pipe visible on landward side--recommend clearing. Good candidate for pressure test or video inspection due to signs of heavy corrosion. If no leaks after tests this crossing would be a good candidate for rehabilitation. (O. Magana - DWR UCIP) FIELD_STRUCT_DESC: 24-inch CIPP-lined corrugated metal gravity drainage pipe (CMP) through the levee, 9.2 feet below the crown. Flap gate on the waterside (WS) end. Concrete headwall on each end. [Additional Reference(s): DWR Levee Log, 2002, (HLM 8.51). USACE San Joaquin O&M Manual, Unit No. 601, Part No. 1, 1967, Amended in 1978, Revised 20 June 1985, (HLM 8.51). DWR As-Built Specification No. 61-01, Sheet No. 51, 7 March 1961, (HLM 8.51)]. FS Date: 7/13/2021

LS view: Inside pipe inlet at toe, slightly rusted inside.

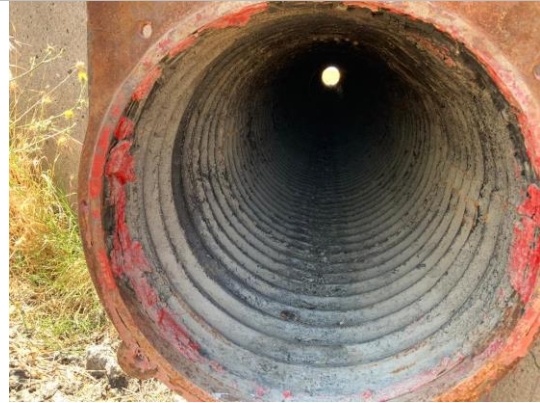
Photo 2 of 2 : UCIP_FA_2024_71117_102253.jpg

WS view: Inside pipe outlet at toe.

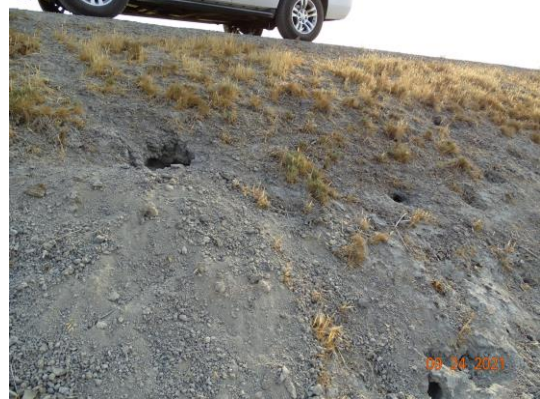
Photo 1 of 1 : FA_2024_NA0010_124_121_20240828_00046.jpg

LM Start	8.61	Rating **	A/W	Issue No.	121
LM End	8.69	Issue Type +	Ma	Location *	LS
Category	Earthen Levee			GPS Latitude/Longitude	
				Start	End
Item	Animal Control			37.211700 °	37.210809 °
				-120.706976 °	-120.706106 °
DWR ID	DWR_NA0010_06_f_2021_121				
Comment Code					
A1 : Exterminate rodents and backfill and compact or grout burrows.					
Inspector Comment

Looking at rodent holes in the landside slope. (Fall 2021)

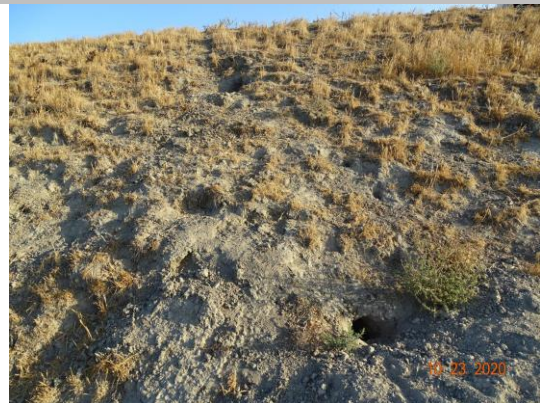
Photo 1 of 1 : FA_2024_NA0010_124_103_20240828_00034.jpg

LM Start	9.67	Rating **	M	Issue No.	103
LM End	9.71	Issue Type +	Ma	Location *	LS
Category	Earthen Levee			GPS Latitude/Longitude	
				Start	End
Item	Animal Control			37.200934 °	37.200836 °
				-120.694084 °	-120.693406 °
DWR ID	DWR_NA0010_06_f_2020_103				
Comment Code					
A1 : Exterminate rodents and backfill and compact or grout burrows.					
Inspector Comment

Rodent holes in the landside slope. (Fall 2020)

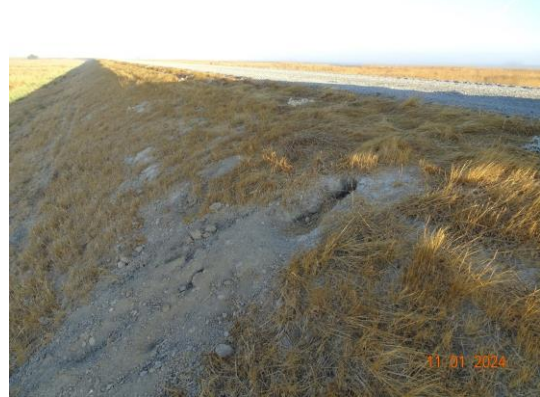
Photo 1 of 1 : FA_2024_NA0010_124_82_20241105_00152.jpg

LM Start	10.11	Rating **	M	Issue No.	82
LM End	10.11	Issue Type +	Ma	Location *	LS
Category	Earthen Levee			GPS Latitude/Longitude	
				Start	End
Item	Animal Control			37.196993 °	37.196993 °
				-120.688086 °	-120.688086 °
DWR ID	DWR_NA0010_06_f_2024_82				
Comment Code					
A3 : No rodents visible, but rodent burrows visible; need to backfill and compact or grout burrows.					
Inspector Comment

View of animal burrows on the landside slope. (Fall 2024)
