Flood Control Project Maintenance Levee Inspections

Fall 2024 Levee Maintenance Deficiency Summary Report

San Joaquin River Basin

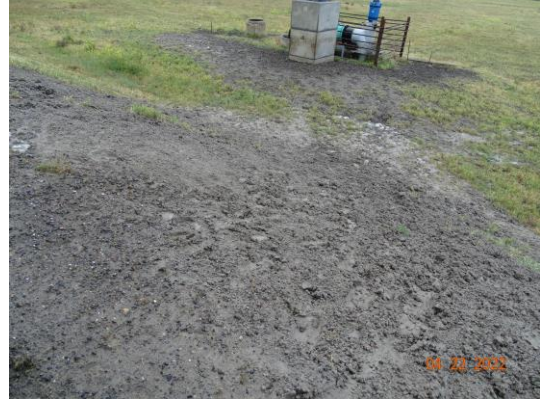
Photo 1 of 1 : FA_2024_NA0010_124_141_20240828_00060.jpg

LM Start	10.96	Rating **	A/W	Issue No.	141
LM End	10.96	Issue Type +	Ma	Location *	LS
Category	Earthen Levee			GPS Latitude/Longitude	
				Start	End
Item	Erosion / Livestock			37.187999°	37.187999°
				-120.677522°	-120.677522°
DWR ID	DWR_NA0010_06_s_2022_141				
Comment Code					
E4 : Repair the levee slope damaged by livestock and prevent large animal access.					
Inspector Comment

View of damage to the landside slope. (Spring 2022)

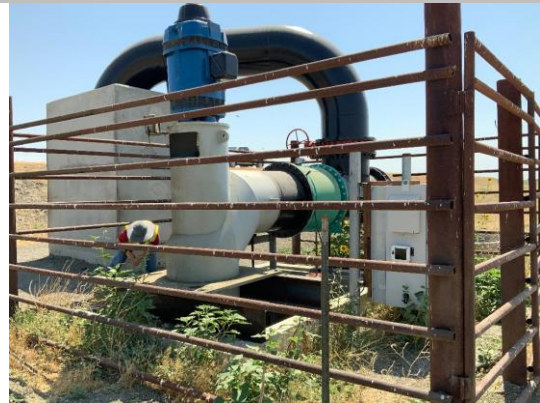
Photo 1 of 1 : UCIP_FA_2024_71128_102319.jpg

Comment Code						
Inspector Comment						
DS_ID:19563 FS_ID:71128 EP_NO: 18624 Repair Type: Non-Urgent EVAL Issue: 10, Unauthorized Modification or Non-Compliant Permit Crossing Status: Found UCIP Comments: 07/13/2021 The record has been upgraded from No Action Needed to Non-Urgent. WS outlets were underwater at time of inspection, limited inspection. There appears to be a new pump and pipe system off the LS toe. Confirm with owner on the status of this crossing. The UCIP inspection was completed with GEI staff, P. Espinoza. (H. Dunn ? GEI) FIELD_STRUCT_DESC: 36-inch reinforced concrete water supply pipe (RCP) through the levee, 5.0 feet below the crown. Pipe riser units on both the inlet and the outlet sides. Control gate on the landside (LS). Slide gate on the waterside (WS) end. Joints secured in hoop steel and encased in concrete at each levee toe. (36-inch water pipe authorized under Permit No. 18624, 2010 - Wolfsen Land and Cattle Company). FS Date: 7/13/2021

LS view: New pump and pipe system off the toe.

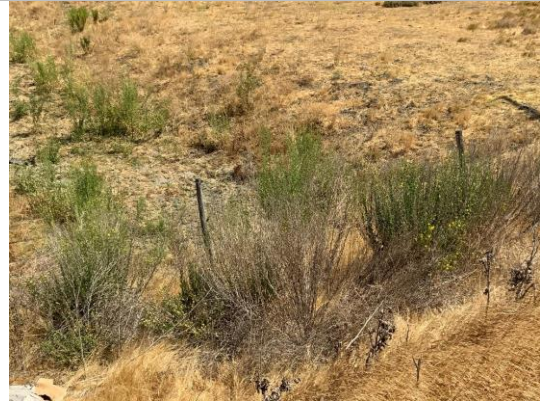
Photo 2 of 2 : UCIP_FA_2024_71150_102323.jpg

WS view: Lower slope, flapgate covered by barbed wire and dense vegetation.

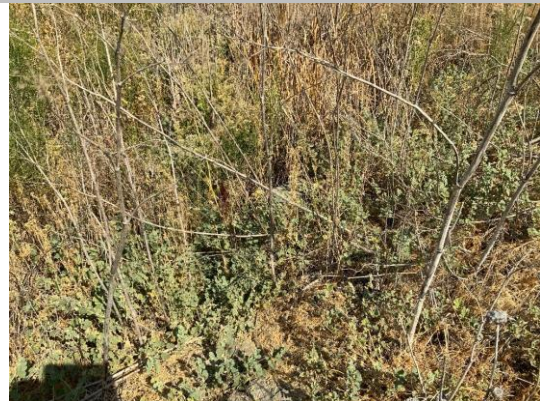
Photo 1 of 2 : UCIP_FA_2024_81022_102328.jpg

DS_ID:19876
FS_ID:81022
EP_NO: N/A
Repair Type: Urgent
EVAL Issue: 1, Pipe Integrity
Crossing Status: Found
UCIP Comments: 09/19/2023 Record updated from Non-Urgent to Urgent. DMP internal video inspection has found severe pipe defects. Crossing will be monitored until funding becomes available to address the issues. (O. Yakimov - DWR UCIP)
07/13/2021 The record remains Non-Urgent. Dense vegetation over LS inlet and WS outlet, recommend removal of vegetation from both sides. Limited inspection of both inlet and outlet. No permit was found authorizing this encroachment. CVFPB will need to review crossing to determine owner. The UCIP inspection was completed with GEI staff, P. Espinoza. (H. Dunn ? GEI)04/17/2014 Clear debris from waterward and landward toes. (O. Magana - DWR UCIP)
FIELD_STRUCT_DESC: 36-inch corrugated metal gravity drainage pipe (CMP) through the levee, 17.0 feet below the crown. Slide gate in a pipe riser unit on the waterside (WS) slope. [Additional Reference(s): DWR Levee Log, 2002, (HLM 11.83). USACE San Joaquin O&M Manual, Unit No. 601, Part No. 1, 1967, Amended in 1978, Revised 20 June 1985, (HLM 11.82). DWR As-Built Specification No. 59-01, Sheet No. 66, 10 December 1958, (HLM 11.82)].

WS view: Flapgate barely visible under dense vegetation at toe.

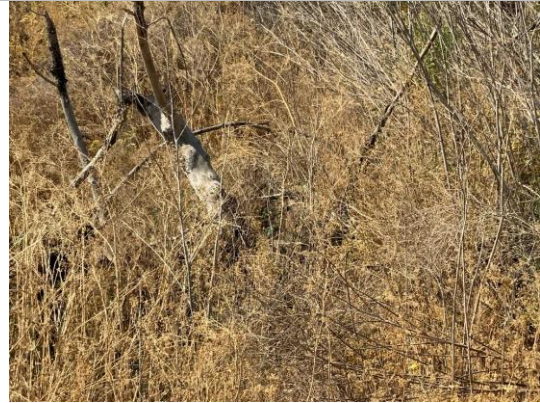
Photo 2 of 2 : UCIP_FA_2024_81022_102333.jpg

LS view: Headwall and inlet covered by dense vegetation at toe.

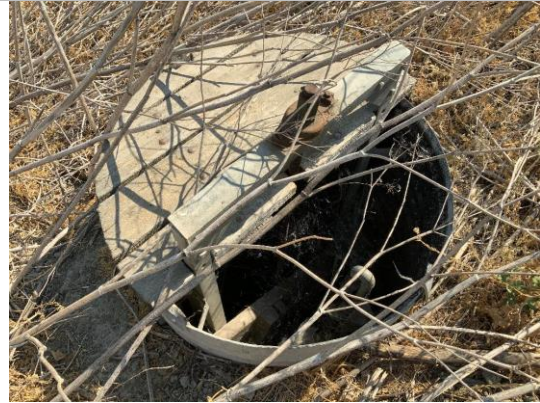
Photo 2 of 3 : UCIP_FA_2024_71152_102337.jpg

DS_ID:19877
FS_ID:71152
EP_NO: N/A
Repair Type: Non-Urgent
EVAL Issue: 4b, Safety Issue
Crossing Status: Found
UCIP Comments: 07/13/2021 The record remains Non-Urgent. Partial cover on WS riser, recommend repair for safety reasons. Limited inspection due to LS pipe inlet being overed with vegetation, headwall barely visible, recommend removal. WS outlet not found, possibly buried under dirt or vegetaion. Recommend removal of vegetation and dirt to uncover WS pipe outlet. No permit was found authorizing this encroachment. CVFPB will need to review crossing to determine owner. The UCIP inspection was completed with GEI staff, P. Espinoza. (H. Dunn ? GEI)04/17/2014 Not accessible--crossing is buried on landward side. Need to contact owner to determine status. (O. Magana - DWR UCIP)
FIELD_STRUCT_DESC: 24-inch corrugated metal gravity drainage pipe (CMP) through the levee, 10.8 feet below the crown. Flap gate on the waterside (WS) end. [Additional Reference(s): DWR Levee Log, 2002, (HLM 13.31). USACE San Joaquin O&M Manual, Unit No. 601, Part No. 1, 1967, Amended in 1978, Revised 20 June 1985, (HLM 13.30). DWR As-Built Specification No. 59-01, Sheet No. 67, 10 December 1958, (HLM 13.30)].

WS view: Closeup of riser on slope, broken lid.

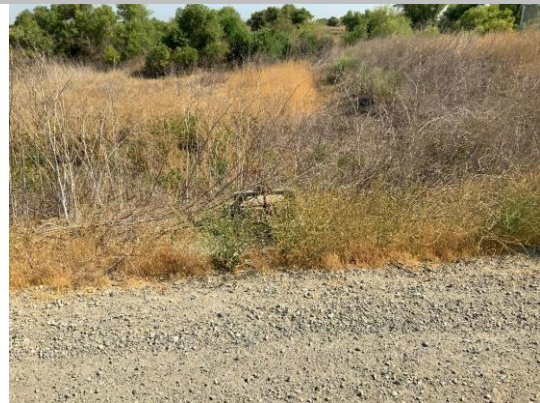
Photo 3 of 3 : UCIP_FA_2024_71152_102336.jpg

WS view: Riser visible on slope from crown.

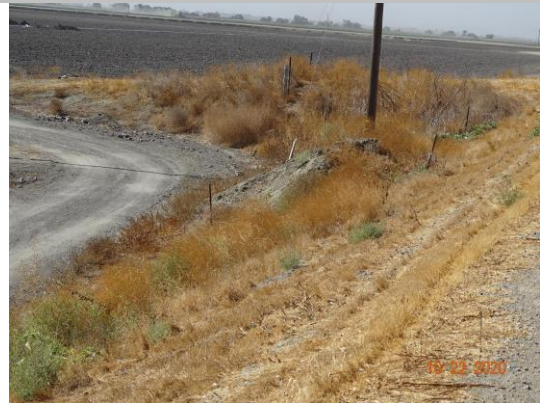
Photo 1 of 1 : FA_2024_NA0010_124_68_20240828_00016.jpg

LM Start	13.24	Rating **	M	Issue No.	68
LM End	13.24	Issue Type +	En	Location *	LS
Category	Earthen Levee			GPS Latitude/Longitude	
				Start	End
Item	Encroachments			37.171686 °	37.171686 °
				-120.654562 °	-120.654562 °
DWR ID	DWR_NA0010_06_f_2015_68				
Comment Code					
MA : Material					
Inspector Comment					
Landowner stockpiled dirt at landside toe.

Looking downstream at dirt stockpile on the landside toe. (Fall 2020)

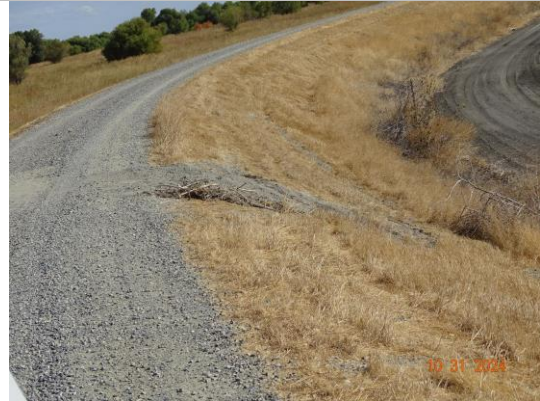
Photo 1 of 1 : FA_2024_NA0010_124_120_20241105_00153.jpg

LM Start	14.00	Rating **	A/W	Issue No.	120
LM End	14.00	Issue Type +	Ma	Location *	LS
Category	Earthen Levee			GPS Latitude/Longitude	
				Start	End
Item	Slope Stability			37.171591 °	37.171591 °
				-120.640938 °	-120.640938 °
DWR ID	DWR_NA0010_06_f_2021_120				
Comment Code					
S1 : Repair slope instability.					
Inspector Comment					
Slip has been repaired with loose soil. Monitor for possible settlement and erosion.

View of repaired landside slope. (Fall 2024)

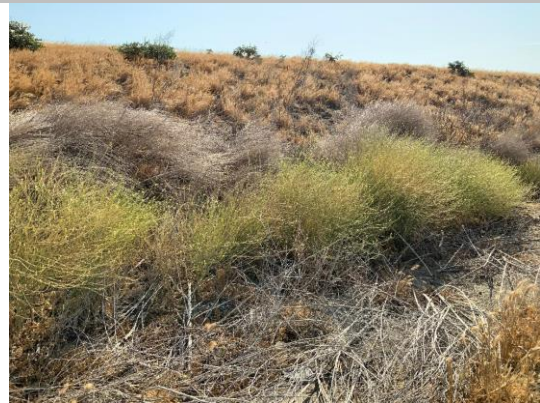
Photo 1 of 1 : UCIP_FA_2024_71153_102397.jpg

Comment Code					
Inspector Comment					
DS_ID:19878 FS_ID:71153 EP_NO: N/A Repair Type: Non-Urgent EVAL Issue: 11, Maintenance Compliance Issue Crossing Status: Found UCIP Comments: 07/13/2021 The record remains Non-Urgent. Limited inspection due to LS pipe inlet not being found, assuming its completely buried. Recommend removing dirt and vegetation to find alignment and confirming with owner on the status of this pipe. No permit was found authorizing this encroachment. CVFPB will need to review crossing to determine owner. The UCIP inspection was completed with GEI staff, P. Espinoza. (H. Dunn ? GEI)04/17/2014 Not accessible--crossing is buried on landward side. Need to contact owner to determine status. (O. Magana - DWR UCIP) FIELD_STRUCT_DESC: 24-inch corrugated metal gravity drainage pipe (CMP) through the levee, 12.3 feet below the crown. Flap gate on the waterside (WS) end. [Additional Reference(s): DWR Levee Log, 2002 (HLM 14.45). USACE San Joaquin O&M Manual, Unit No. 601, Part No. 1, 1967, Amended in 1978, Revised 20 June 1985, (HLM 14.44). DWR As-Built Specification No. 59-01, Sheet No. 68, 10 December 1958, (HLM 14.44)]. FS Date: 7/13/2021

LS view: Slope from toe, no pipe visible.

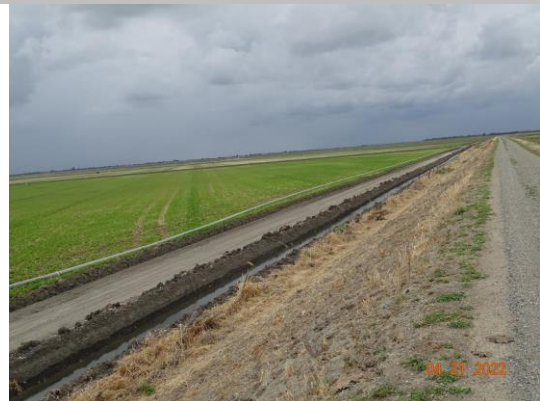
Photo 1 of 1 : FA_2024_NA0010_124_119_20240828_00044.jpg

LM Start	14.71	Rating **	A/W	Issue No.	119
LM End	15.23	Issue Type +	En	Location *	LS
Category	Earthen Levee			GPS Latitude/Longitude	
				Start	End
Item	Encroachments			37.164000 °	37.160390 °
				-120.632225 °	-120.623995 °
DWR ID	DWR_NA0010_06_f_2021_119				
Comment Code					
DT : Ditch					
Inspector Comment					
Ditch dug approximate 5 - 15 feet from the landside toe.

Ditch landowner has dug on the landside toe. (Spring 2022)

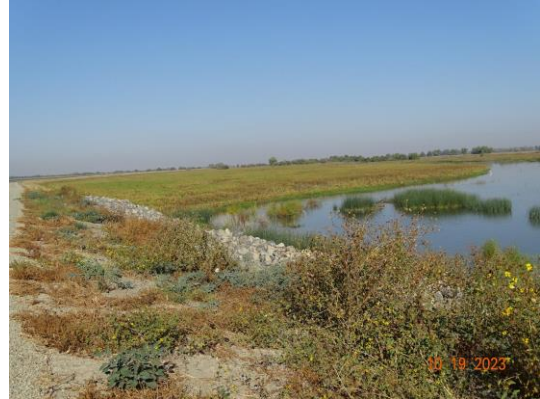
Photo 1 of 1 : FA_2024_NA0010_124_144_20240828_00062.jpg

LM Start	14.93	Rating **	A/W	Issue No.	144
LM End	15.00	Issue Type +	Ma	Location *	WS
Category	Earthen Levee			GPS Latitude/Longitude	
				Start	End
Item	Riprap Revetments			37.162295°	37.161858°
				-120.628897°	-120.627784°
DWR ID	DWR_NA0010_06_f _ 2023_144				
Comment Code					
RR : Riprap Revetments					
Inspector Comment

View of revetment protected waterside slope. (Fall 2023)

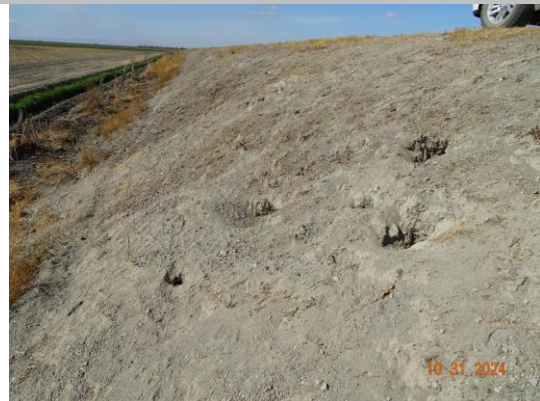
Photo 1 of 1 : FA_2024_NA0010_124_78_20241105_00154.jpg

LM Start	15.19	Rating **	M	Issue No.	78
LM End	15.19	Issue Type +	Ma	Location *	LS
Category	Earthen Levee			GPS Latitude/Longitude	
				Start	End
Item	Animal Control			37.160636 °	37.160636 °
				-120.624669 °	-120.624669 °
DWR ID	DWR_NA0010_06_f_2024_78				
Comment Code					
A3 : No rodents visible, but rodent burrows visible; need to backfill and compact or grout burrows.					
Inspector Comment

View of multiple animal burrows on the landside slope. (Fall 2024)

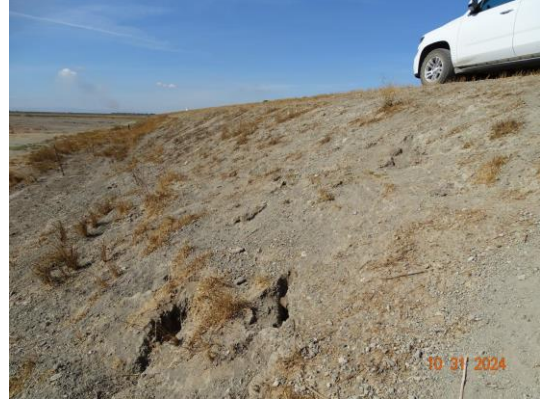
Photo 1 of 1 : FA_2024_NA0010_124_124_20241105_00155.jpg

LM Start	15.28	Rating **	U	Issue No.	124
LM End	15.61	Issue Type +	Ma	Location *	LS
Category	Earthen Levee			GPS Latitude/Longitude	
				Start	End
Item	Animal Control			37.160104°	37.157640°
				-120.623317°	-120.618180°
DWR ID	DWR_NA0010_06_s_2012_124				
Comment Code					
A1 : Exterminate rodents and backfill and compact or grout burrows.					
Inspector Comment

View of multiple animal burrows on the landside slope. (Fall 2024)

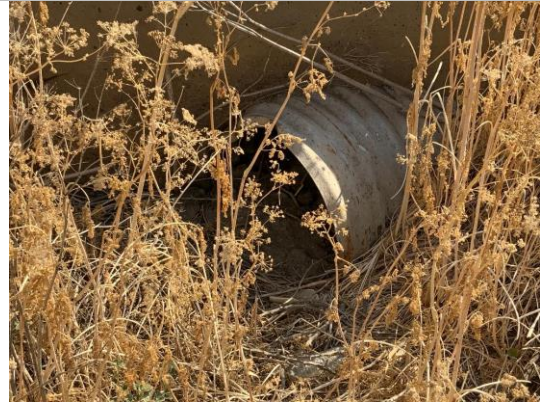
Photo 1 of 2 : UCIP_FA_2024_84935_102351.jpg

Comment Code						
Inspector Comment						
DS_ID:19884 FS_ID:84935 EP_NO: N/A Repair Type: Urgent EVAL Issue: 1, Pipe Integrity Crossing Status: Found UCIP Comments: 12/14/2022 Record updated from Non-Urgent to Urgent. DMP internal video inspection has found pipe integrity issues. LOF of crossing is between 5 and 6. Crossing will be monitored until funding becomes available to address the issues. (O.Yakimov - DWR UCIP) 07/13/2021 The record remains Non-Urgent. Limited inspection of LS pipe inlet. LS pipe edges are warped and inlet filled with sediment and some vegetation, recommend cleaning out. No permit was found authorizing this encroachment. CVFPB will need to review crossing to determine owner. The UCIP inspection was completed with GEI staff, P. Espinoza. (H. Dunn ? GEI)04/17/2014 Need to contact owner. Sediment buildup on both the waterward and landward side. Recommend removing sediment buildup from both side. Also recommend clearing excess sediment inside crossing. (O. Magana - DWR UCIP) FIELD_STRUCT_DESC: 24-inch corrugated metal gravity drainage pipe (CMP) through the levee, 14.0 feet below the crown. Flap gate on the waterside (WS) end. [Additional Reference(s): DWR Levee Log, 2002, (HLM 15.78). USACE San Joaquin O&M Manual, Unit No. 601, Part No. 1, 1967, Amended in 1978, Revised 20 June 1985, (HLM 15.76). DWR As-Built Specification No. 59-01, Sheet No. 69, 10 December 1958, (HLM 15.76)]. FS Date: 7/13/2021 2:03:17 PM

LS view: Closeup of pipe inlet at toe with sediment buildup.

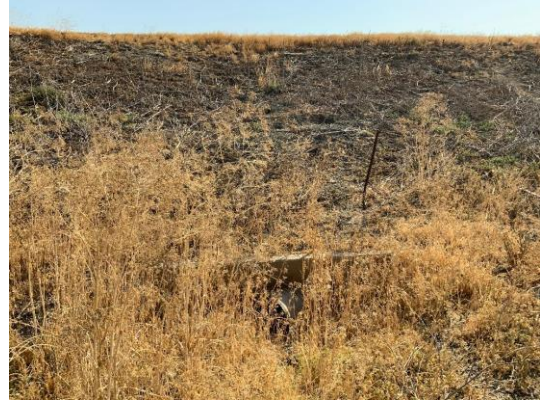
Photo 2 of 2 : UCIP_FA_2024_84935_102350.jpg

LS view: Headwall visible at toe.

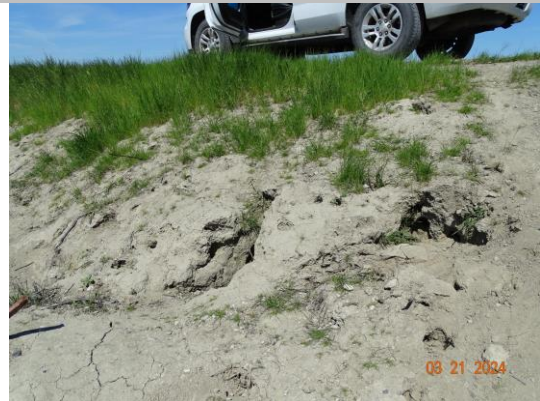
Photo 1 of 1 : FA_2024_NA0010_124_56_20240828_00011.jpg

LM Start	15.68	Rating **	M	Issue No.	56
LM End	15.68	Issue Type +	Ma	Location *	LS
Category	Earthen Levee			GPS Latitude/Longitude	
				Start	End
Item	Animal Control			37.156889 °	37.156889 °
				-120.617165 °	-120.617165 °
DWR ID	DWR_NA0010_06_s_2024_56				
Comment Code					
A3 : No rodents visible, but rodent burrows visible; need to backfill and compact or grout burrows.					
Inspector Comment

View of rodent burrows on the landside slope. (Spring 2024)

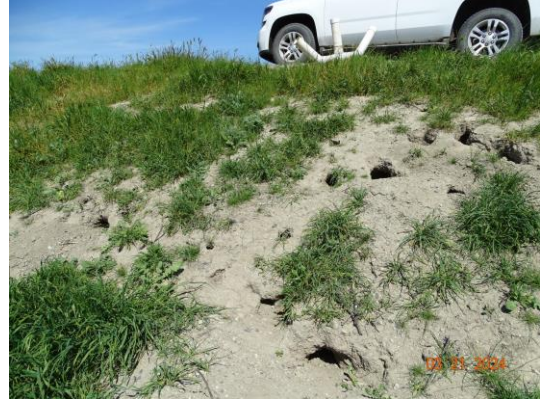
Photo 1 of 1 : FA_2024_NA0010_124_54_20240828_00010.jpg

LM Start	16.33	Rating **	M	Issue No.	54
LM End	16.33	Issue Type +	Ma	Location *	LS
Category	Earthen Levee			GPS Latitude/Longitude	
				Start	End
Item	Animal Control			37.150606 °	37.150606 °
				-120.608552 °	-120.608552 °
DWR ID	DWR_NA0010_06_s_2024_54				
Comment Code					
A3 : No rodents visible, but rodent burrows visible; need to backfill and compact or grout burrows.					
Inspector Comment					
LMA has placed bait stations along this section.

Several rodent burrows observed along this section. (Spring 2024)

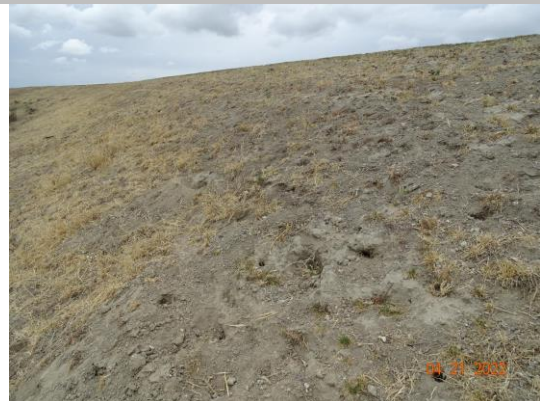
Photo 1 of 1 : FA_2024_NA0010_124_115_20240828_00041.jpg

LM Start	17.10	Rating **	M	Issue No.	115
LM End	17.13	Issue Type +	Ma	Location *	LS
Category	Earthen Levee			GPS Latitude/Longitude	
				Start	End
Item	Animal Control			37.141678 °	37.141305 °
				-120.600221 °	-120.599949 °
DWR ID	DWR_NA0010_06_f_2021_115				
Comment Code					
A1 : Exterminate rodents and backfill and compact or grout burrows.					
Inspector Comment

Looking along the landside slope at rodent burrows. (Spring 2022)

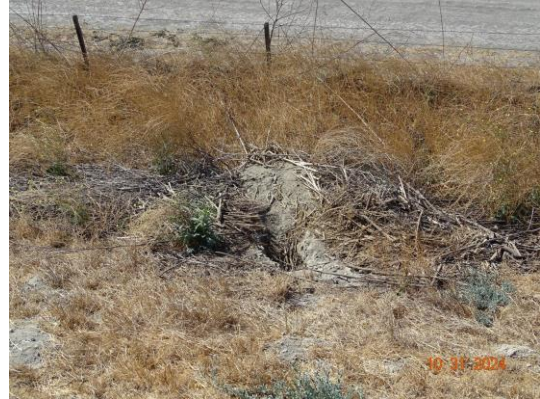
Photo 1 of 1 : FA_2024_NA0010_124_71_20241105_00156.jpg

LM Start	17.24	Rating **	U	Issue No.	71
LM End	17.24	Issue Type +	Ma	Location *	LS
Category	Earthen Levee			GPS Latitude/Longitude	
				Start	End
Item	Animal Control			37.139776°	37.139776°
				-120.598999°	-120.598999°
DWR ID	DWR_NA0010_06_f_2024_71				
Comment Code					
A3 : No rodents visible, but rodent burrows visible; need to backfill and compact or grout burrows.					
Inspector Comment

View of large animal burrow on the landside toe. (Fall 2024)

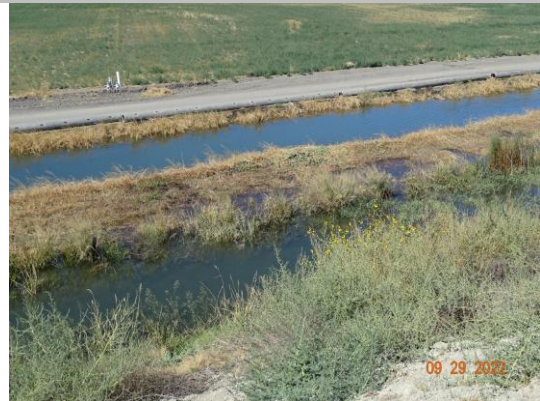
Photo 1 of 1 : FA_2024_NA0010_124_153_20240828_00068.jpg

LM Start	17.79	Rating **	A/W	Issue No.	153
LM End	18.77	Issue Type +	En	Location *	LS
Category	Earthen Levee			GPS Latitude/Longitude	
				Start	End
Item	Encroachments			37.133023°	37.119876°
				-120.593812°	-120.587457°
DWR ID	DWR_NA0010_06_f_2022_153				
Comment Code					
DT : Ditch					
Inspector Comment					
The ditch is located outside of the easement but water appeared to be seeping through the ditch walls and causing water to pool on the landside toe.

Seepage on the landside toe from the nearby ditch. (Fall 2022)

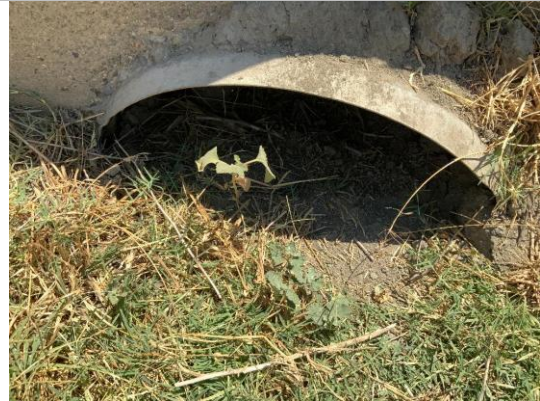
Photo 1 of 2 : UCIP_FA_2024_84936_101421.jpg

Comment Code						
Inspector Comment						
DS_ID:19887 FS_ID:84936 EP_NO: N/A Repair Type: Urgent EVAL Issue: 1, Pipe Integrity Crossing Status: Found UCIP Comments: 12/14/2022 Record updated from Non-Urgent to Urgent. DMP internal video inspection has found pipe integrity issues. LOF of crossing is between 5 and 6. Crossing will be monitored until funding becomes available to address the issues. (O.Yakimov - DWR UCIP) 07/12/2021 The record remains Non-Urgent. LS pipe inlet filled with sediment, recommend removal. WS flapgate has some vegetation over it, recommend removal. Limited inspection on both WS and LS. No permit was found authorizing this encroachment. CVFPB will need to review crossing to determine owner. The UCIP inspection was completed with GEI staff, P. Espinoza. (H. Dunn ? GEI)04/17/2014 Sediment build up on landward side toe -- debris blockage. No photos available. Recommend taking photos of crossing. (O. Magana - DWR UCIP) FIELD_STRUCT_DESC: 24-inch corrugated metal gravity drainage pipe (CMP) through the levee, 11.5 feet below the crown. Flap gate on the waterside (WS) end. [Additional Reference(s): DWR Levee Log, 2002, (HLM 18.29). USACE San Joaquin O&M Manual, Unit No. 601, Part No. 1, 1967, Amended in 1978, Revised 20 June 1985, (HLM 18.27). DWR As-Built Specification No. 59-01, Sheet No. 70, 10 December 1958, (HLM 18.27)]. FS Date: 7/13/2021 2:03:37 PM

LS view: Closeup of pipe inlet at toe filled with sediment.

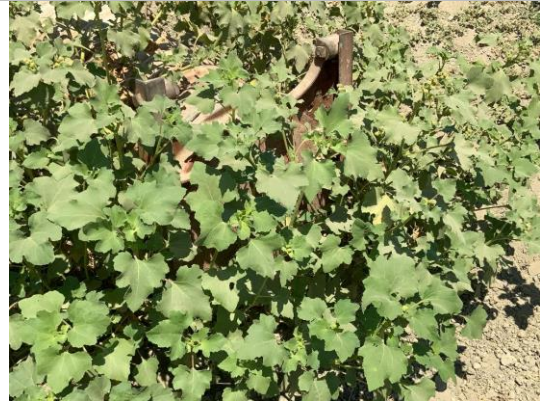
Photo 2 of 2 : UCIP_FA_2024_84936_101424.jpg

LM Start	18.20	Rating **	U	Issue No.	1243 (cont)
LM End	18.20	Issue Type +	Ma	Location *	
Category	Supplemental			GPS Latitude/Longitude	
				Start	End
Item	DWR UCIP LMA Responsibility			37.127773 °	37.127773 °
				-120.590809 °	-120.590809 °
DWR ID	19887

WS view: Closeup of flapgate at toe covered with vegetation.

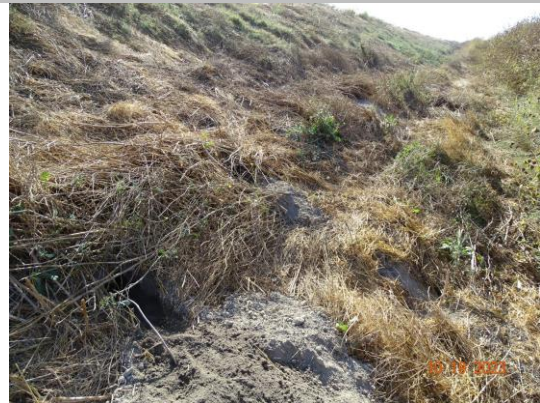
Photo 1 of 1 : FA_2024_NA0010_124_128_20240828_00051.jpg

LM Start	18.70	Rating **	M	Issue No.	128
LM End	18.70	Issue Type +	Ma	Location *	LS
Category	Earthen Levee			GPS Latitude/Longitude	
				Start	End
Item	Animal Control			37.120792 °	37.120792 °
				-120.587878 °	-120.587878 °
DWR ID	DWR_NA0010_06_f_2023_128				
Comment Code					
A3 : No rodents visible, but rodent burrows visible; need to backfill and compact or grout burrows.					
Inspector Comment

View of rodent holes along the landside slope. (Fall 2023)

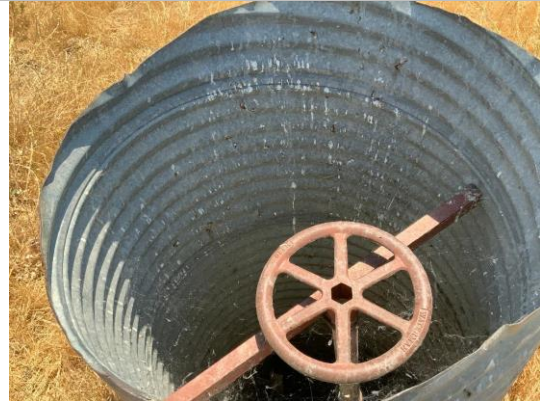
Photo 1 of 2 : UCIP_FA_2024_71139_101555.jpg

DS_ID:19889
FS_ID:71139
EP_NO: N/A
Repair Type: Non-Urgent
EVAL Issue: 4b, Safety Issue
Crossing Status: Found
UCIP Comments: 09/25/2024 DMP internal video inspection has found moderate pipe defects. Crossing will be monitored until funding becomes available for rehabilitation. (O. Yakimov - DWR UCIP)
07/12/2021 The record remains Non-Urgent. Barbed wire over LS end, could not inspect closely. No cover over WS riser, causing safety hazard. Slightly warped edges on both WS and LS pipe inlet/outlet. No permit was found authorizing this encroachment. CVFPB will need to review crossing to determine owner. The UCIP inspection was completed with GEI staff, P. Espinoza. (H. Dunn ? GEI)04/17/2014
Dense vegetation limits the inspector's visibility to identify signs of pipe failure (leaks) along the landward slope. Recommend removing vegetation along pipe alignment to conduct proper inspection of structure. (O. Magana - DWR UCIP)

WS view: Riser missing cover on slope.

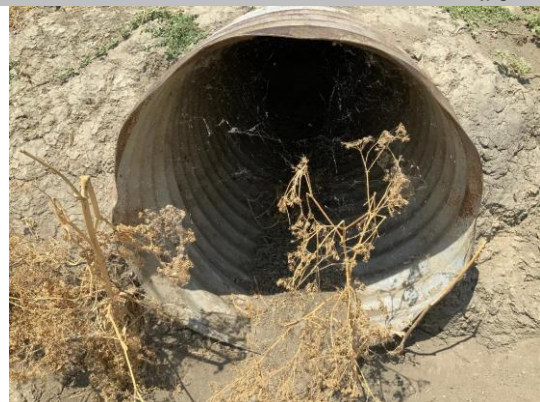
Photo 2 of 2 : UCIP_FA_2024_71139_101557.jpg

WS view: Closeup of pipe outlet at toe with slightly warped edges.

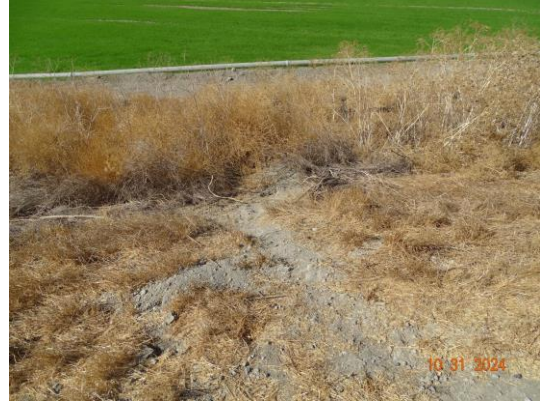
Photo 1 of 1 : FA_2024_NA0010_124_63_20241105_00157.jpg

LM Start	19.06	Rating **	M	Issue No.	63
LM End	19.06	Issue Type +	Ma	Location *	LS
Category	Earthen Levee			GPS Latitude/Longitude	
				Start	End
Item	Animal Control			37.115776 °	37.115776 °
				-120.587018 °	-120.587018 °
DWR ID	DWR_NA0010_06_f _ 2024_63				
Comment Code					
A3 : No rodents visible, but rodent burrows visible; need to backfill and compact or grout burrows.					
Inspector Comment

View of multiple animal burrows on the landside slope. (Fall 2024)

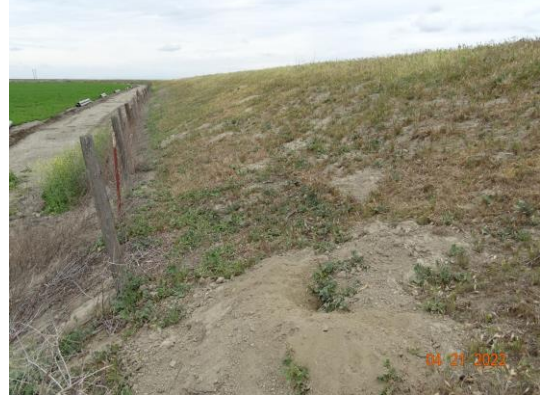
Photo 1 of 1 : FA_2024_NA0010_124_136_20240828_00057.jpg

LM Start	19.18	Rating **	M	Issue No.	136
LM End	19.22	Issue Type +	Ma	Location *	LS
Category	Earthen Levee			GPS Latitude/Longitude	
				Start	End
Item	Animal Control			37.114272 °	37.113716 °
				-120.587857 °	-120.588225 °
DWR ID	DWR_NA0010_06_s_2022_136				
Comment Code					
A3 : No rodents visible, but rodent burrows visible; need to backfill and compact or grout burrows.					
Inspector Comment

Looking downstream along the landside slope at rodent burrows. (Spring 2022)

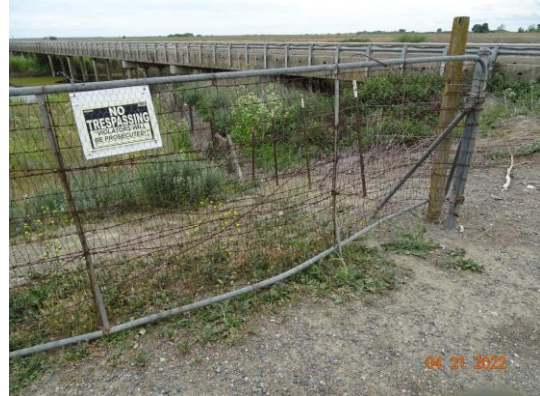
Photo 1 of 1 : FA_2024_NA0010_124_135_20240828_00056.jpg

LM Start	19.23	Rating **	M	Issue No.	135
LM End	19.23	Issue Type +	Ma	Location *	CR
Category	Earthen Levee			GPS Latitude/Longitude	
				Start	End
Item	Access Gates			37.113581 °	37.113581 °
				-120.588310 °	-120.588310 °
DWR ID	DWR_NA0010_06_s_2022_135				
Comment Code					
AG : Access Gates					
Inspector Comment					
Bottom of gate has broken off near hinge causing the gate to drag.

View of access gate with a broken bottom hinge. (Spring 2022)

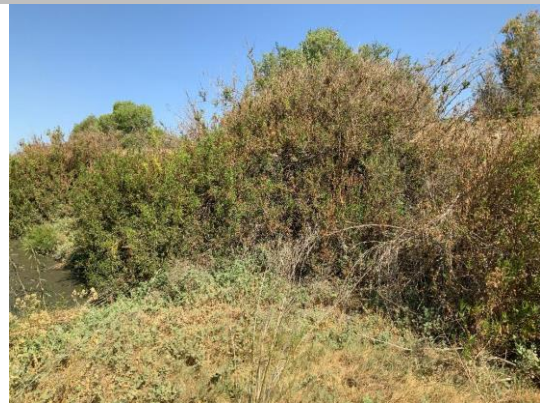
Photo 1 of 2 : UCIP_FA_2024_71141_101579.jpg

Comment Code					
Inspector Comment					
DS_ID:19891 FS_ID:71141 EP_NO: N/A Repair Type: Non-Urgent EVAL Issue: 11, Maintenance Compliance Issue Crossing Status: Found UCIP Comments: 07/12/2021 The record remains Non-Urgent. Limited inspection due to dense vegetation on LS and WS ends, LS headwall just barely visible, recommend removal of vegetation. No permit was found authorizing this encroachment. CVFPB will need to review crossing to determine owner. The UCIP inspection was completed with GEI staff, P. Espinoza. (H. Dunn ? GEI)04/17/2014 Dense vegetation limits the inspector's visibility to identify signs of pipe failure (leaks) along the slopes. Recommend removing vegetation along pipe alignment to conduct proper inspection of structure. (O. Magana - DWR UCIP) FIELD_STRUCT_DESC: 30-inch by 30-inch reinforced concrete box gravity drainage culvert (RCBC) through the levee, 14.0 feet below the crown. Flap gate on the waterside (WS) end. [Additional Reference(s): DWR Levee Log, 2002, (HLM 19.82). USACE San Joaquin O&M Manual, Unit No. 601, Part No. 1, 1967, Amended in 1978, Revised 20 June 1985, (HLM 19.85). DWR As-Built Specification No. 59-01, Sheet No. 73, 10 December 1958, (HLM 19.85)]. FS Date: 7/12/2021

LS view: Dense vegetation over pipe inlet at toe, pipe not visible.

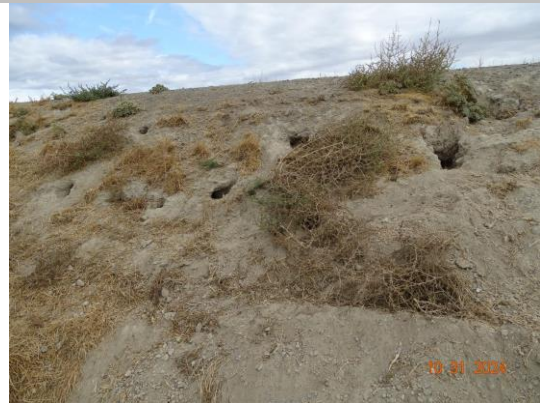
Photo 1 of 1 : FA_2024_NA0010_124_113_20241105_00158.jpg

LM Start	21.30	Rating **	U	Issue No.	113
LM End	21.30	Issue Type +	Ma	Location *	LS
Category	Earthen Levee			GPS Latitude/Longitude	
				Start	End
Item	Animal Control			37.107502°	37.107502°
				-120.557813°	-120.557813°
DWR ID	DWR_NA0010_06_f_2021_113				
Comment Code					
A3 : No rodents visible, but rodent burrows visible; need to backfill and compact or grout burrows.					
Inspector Comment

View of multiple animal burrows on the landside slope. (Fall 2024)

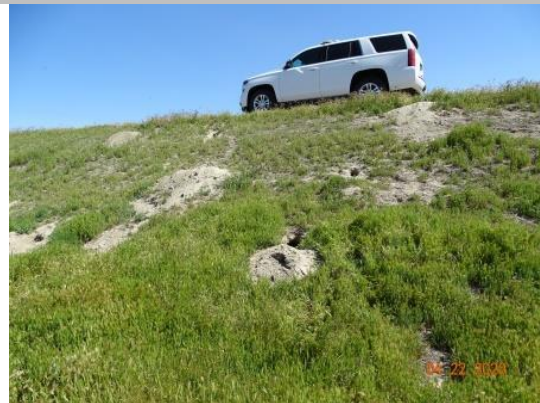
Photo 1 of 1 : FA_2024_NA0010_124_114_20240828_00040.jpg

LM Start	21.39	Rating **	M	Issue No.	114
LM End	21.39	Issue Type +	Ma	Location *	LS
Category	Earthen Levee			GPS Latitude/Longitude	
				Start	End
Item	Animal Control			37.106397 °	37.106397 °
				-120.556727 °	-120.556727 °
DWR ID	DWR_NA0010_06_f_2019_114				
Comment Code					
A3 : No rodents visible, but rodent burrows visible; need to backfill and compact or grout burrows.					
Inspector Comment

View of rodent burrows on the landside slope. (Spring 2020)

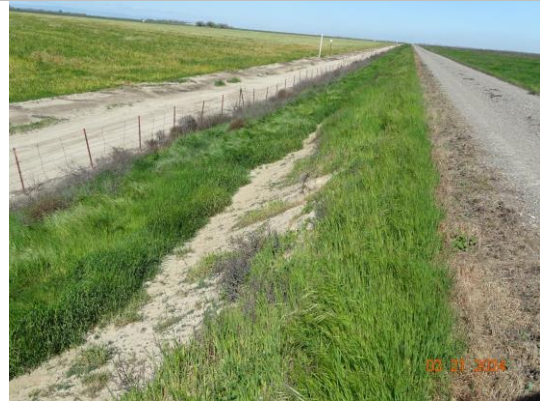
Photo 1 of 1 : FA_2024_NA0010_124_107_20240828_00036.jpg

LM Start	21.71	Rating **	M	Issue No.	107
LM End	21.84	Issue Type +	Ma	Location *	LS
Category	Earthen Levee			GPS Latitude/Longitude	
				Start	End
Item	Erosion / Livestock			37.102844 °	37.101350 °
				-120.553160 °	-120.551666 °
DWR ID	DWR_NA0010_06_f_2018_107				
Comment Code					
E4 : Repair the levee slope damaged by livestock and prevent large animal access.					
Inspector Comment					
Erosion into levee prism due to livestock activities.

View of erosion in landside levee prism. (Spring 2024)

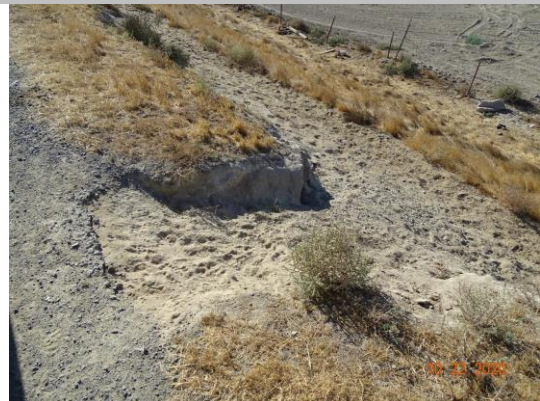
Photo 1 of 1 : FA_2024_NA0010_124_91_20240828_00029.jpg

LM Start	21.82	Rating **	M	Issue No.	91
LM End	22.06	Issue Type +	Ma	Location *	LS
Category	Earthen Levee			GPS Latitude/Longitude	
				Start	End
Item	Erosion / Livestock			37.101617 °	37.098894 °
				-120.551909 °	-120.549178 °
DWR ID	DWR_NA0010_06_f_2020_91				
Comment Code					
E4 : Repair the levee slope damaged by livestock and prevent large animal access.					
Inspector Comment

Cattle trail damage to the landside slope and shoulder. (Fall 2020)

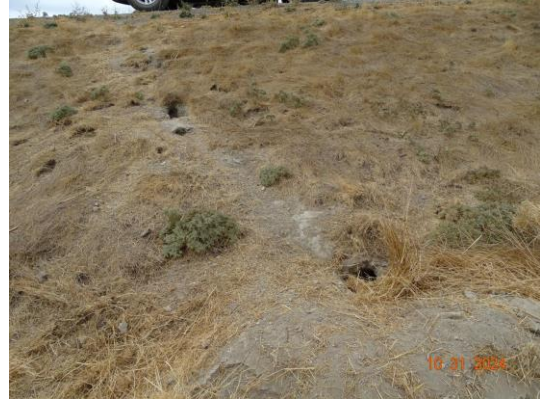
Photo 1 of 1 : FA_2024_NA0010_124_123_20241105_00159.jpg

LM Start	22.00	Rating **	M	Issue No.	123
LM End	22.01	Issue Type +	Ma	Location *	WS
Category	Earthen Levee			GPS Latitude/Longitude	
				Start	End
Item	Animal Control			37.099556 °	37.099420 °
				-120.549876 °	-120.549731 °
DWR ID	DWR_NA0010_06_f _ 2023_123				
Comment Code					
A1 : Exterminate rodents and backfill and compact or grout burrows.					
Inspector Comment

View of multiple animal burrows on the landside slope. (Fall 2024)

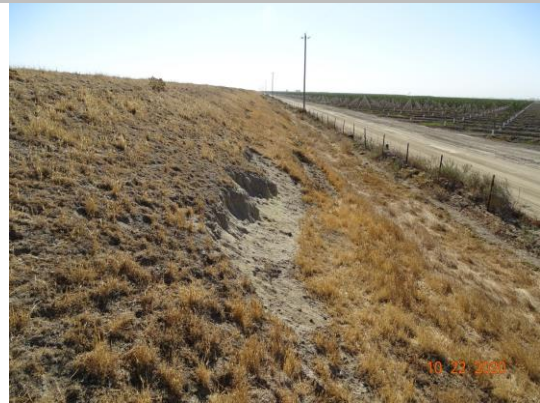
Photo 1 of 1 : FA_2024_NA0010_124_86_20240828_00026.jpg

LM Start	22.09	Rating **	M	Issue No.	86
LM End	22.46	Issue Type +	Ma	Location *	LS
Category	Earthen Levee			GPS Latitude/Longitude	
				Start	End
Item	Erosion / Livestock			37.098524 °	37.094479 °
				-120.548781 °	-120.544435 °
DWR ID	DWR_NA0010_06_f _ 2017_86				
Comment Code					
E4 : Repair the levee slope damaged by livestock and prevent large animal access.					
Inspector Comment					
Erosion greater than 3 inches on landside slope caused by livestock.

Looking upstream along the landside slope. (Fall 2020)

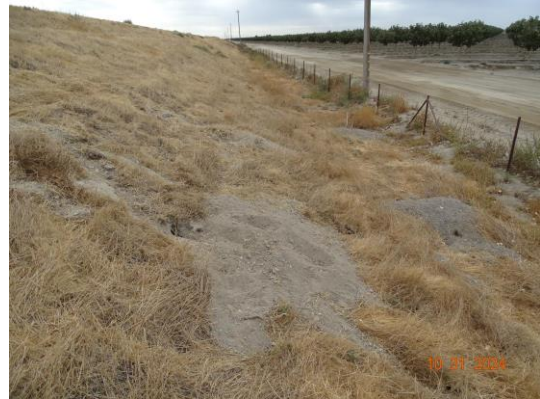
Photo 1 of 1 : FA_2024_NA0010_124_62_20241105_00160.jpg

LM Start	22.50	Rating **	M	Issue No.	62
LM End	22.52	Issue Type +	Ma	Location *	LS
Category	Earthen Levee			GPS Latitude/Longitude	
				Start	End
Item	Animal Control			37.094054 °	37.093808 °
				-120.543991 °	-120.543725 °
DWR ID	DWR_NA0010_06_f_2024_62				
Comment Code					
A3 : No rodents visible, but rodent burrows visible; need to backfill and compact or grout burrows.					
Inspector Comment

View of multiple animal burrows on the landside slope. (Fall 2024)

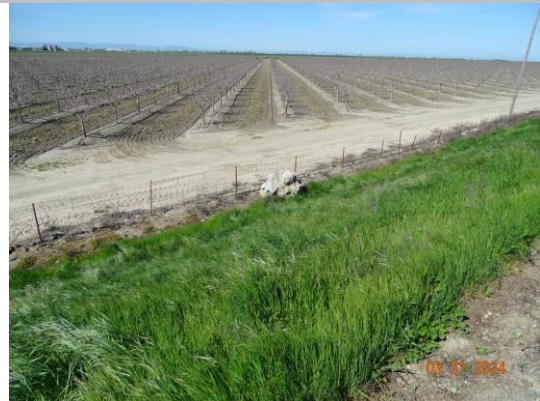
Photo 1 of 1 : FA_2024_NA0010_124_117_20240828_00042.jpg

LM Start	22.87	Rating **	A/W	Issue No.	117
LM End	22.87	Issue Type +	Ma	Location *	LS
Category	Earthen Levee			GPS Latitude/Longitude	
				Start	End
Item	Encroachments			37.089954 °	37.089954 °
				-120.539535 °	-120.539535 °
DWR ID	DWR_NA0010_06_f _ 2019_117				
Comment Code					
DE : Debris					
Inspector Comment					
Large block of concrete left on the landside toe.

Large concrete block left on the landside toe. (Spring 2024)

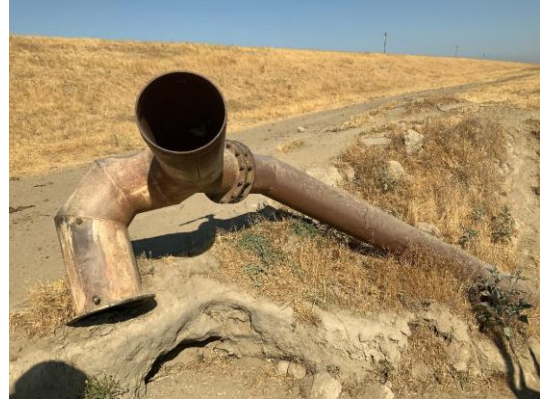
Photo 1 of 1 : UCIP_FA_2024_71142_101603.jpg

Comment Code					
Inspector Comment					
DS_ID:19812 FS_ID:71142 EP_NO: 12657 Repair Type: Non-Urgent EVAL Issue: 10, Unauthorized Modification or Non-Compliant Permit Crossing Status: Found UCIP Comments: 07/12/2021 The record has been upgraded from No Action Needed to Non-Urgent. One of the attached pipes on WS appears to have been removed and is not attached. Unable to access LS riser due to barbed wire. The UCIP inspection was completed with GEI staff, P. Espinoza. (H. Dunn ? GEI) FIELD_STRUCT_DESC: 16-inch coated steel irrigation discharge pipe through the levee, 4.0 feet below the crown. Cutoff wall around the pipe at the center of the levee. Portable pump on the waterside (WS). Concrete standpipe on the landside (LS) slope with a timber walkway access ramp. Siphon breaker on the LS shoulder. Intake trench from the channel to the WS toe. (Diversion pump and discharge pipe authorized under Permit No. 12657, 1979 - Laurie H. Hall, Mary H. Hicks, and William E. Hammonds). [Additional Reference(s): DWR Levee Log, 2002, (HLM 22.82)]. FS Date: 7/12/2021

WS view: Portion of pipe not attached and discarded.

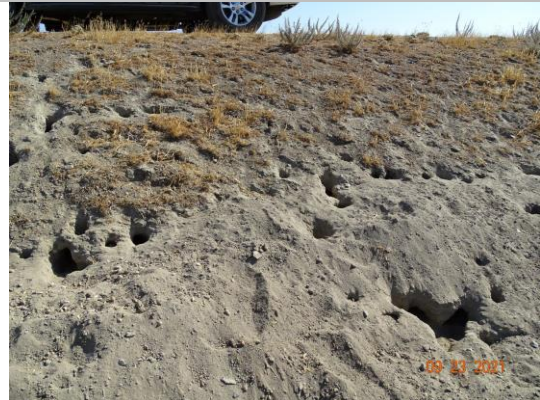
Photo 1 of 1 : FA_2024_NA0010_124_110_20240828_00038.jpg

LM Start	23.05	Rating **	M	Issue No.	110
LM End	23.11	Issue Type +	Ma	Location *	LS
Category	Earthen Levee			GPS Latitude/Longitude	
				Start	End
Item	Animal Control			37.087991 °	37.087312 °
				-120.537430 °	-120.536662 °
DWR ID	DWR_NA0010_06_f_2021_110				
Comment Code					
A3 : No rodents visible, but rodent burrows visible; need to backfill and compact or grout burrows.					
Inspector Comment

View of rodent burrows on the landside slope. (Fall 2021)

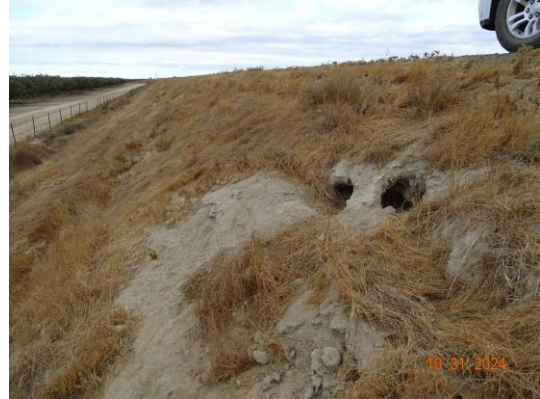
Photo 1 of 1 : FA_2024_NA0010_124_60_20241105_00161.jpg

LM Start	23.27	Rating **	U	Issue No.	60
LM End	23.27	Issue Type +	Ma	Location *	LS
Category	Earthen Levee			GPS Latitude/Longitude	
				Start	End
Item	Animal Control			37.085607 °	37.085607 °
				-120.534844 °	-120.534844 °
DWR ID	DWR_NA0010_06_f_2024_60				
Comment Code					
A3 : No rodents visible, but rodent burrows visible; need to backfill and compact or grout burrows.					
Inspector Comment

View of multiple animal burrows on the landside slope. (Fall 2024)

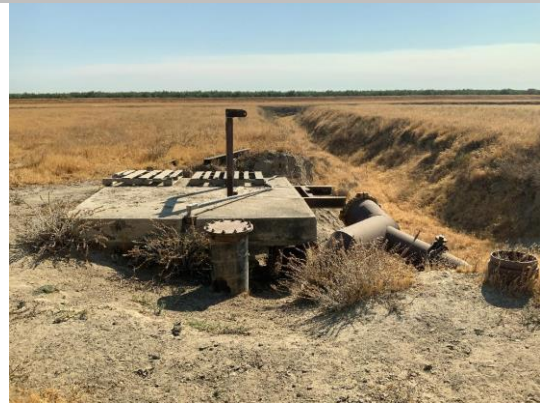
Photo 1 of 2 : UCIP_FA_2024_71143_101613.jpg

Comment Code						
Inspector Comment						
DS_ID:19879 FS_ID:71143 EP_NO: 13638 Repair Type: Non-Urgent EVAL Issue: 10, Unauthorized Modification or Non-Compliant Permit Crossing Status: Found UCIP Comments: 07/12/2021 The record remains Non-Urgent. WS pump removed and wires cut. Large pieces of pipe appear to be out of place, crossing appears abandoned. Pump off LS toe behind fence is running for well water. Recommend contacting owner to confirm status of crossing. Erosion and instability underneath concrete pad meant for pump on the edge of the WS outlet channel. The UCIP inspection was completed with GEI staff, P. Espinoza. (H. Dunn ? GEI)04/17/2014 Need to contact owner to determine status. Crossing has been modified. (O. Magana - DWR UCIP) FIELD_STRUCT_DESC: 16-inch coated steel irrigation discharge pipe through the levee, 3.5 feet below the crown. Cutoff wall around the pipe at the center of the levee. Pump on the waterside (WS). Siphon breaker on the landside (LS) shoulder. Intake trench on the WS. (Pump and 16-inch pipe authorized under Permit No. 13638, 1983 - Hamonds Ranch). [Additional Reference(s): DWR Levee Log, 2002, (HLM 23.92)]. FS Date: 7/12/2021

WS view: Pump removed and pipes displaced at toe.

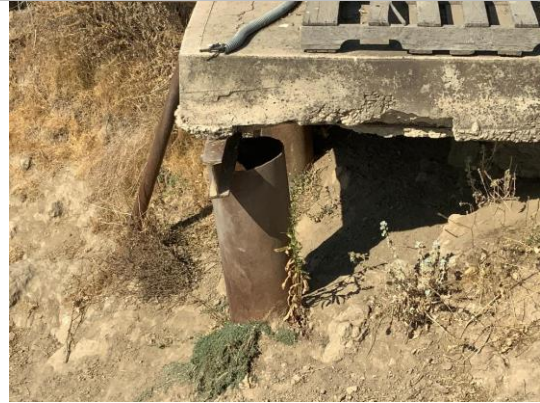
Photo 2 of 2 : UCIP_FA_2024_71143_101617.jpg

WS view: Erosion under concrete pump pad and instability at toe.

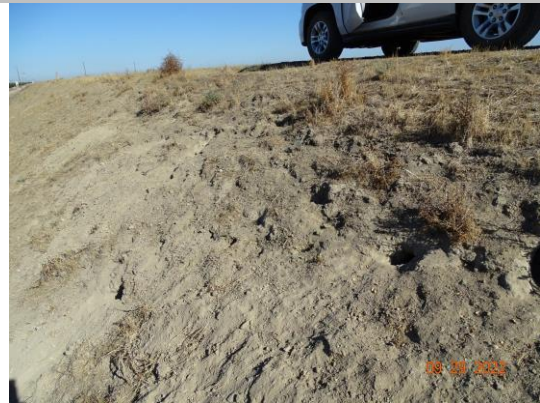
Photo 1 of 1 : FA_2024_NA0010_124_145_20240828_00063.jpg

LM Start	24.06	Rating **	M	Issue No.	145
LM End	24.06	Issue Type +	Ma	Location *	LS
Category	Earthen Levee			GPS Latitude/Longitude	
				Start	End
Item	Animal Control			37.076933 °	37.076933 °
				-120.525444 °	-120.525444 °
DWR ID	DWR_NA0010_06_f_2022_145				
Comment Code					
A3 : No rodents visible, but rodent burrows visible; need to backfill and compact or grout burrows.					
Inspector Comment

Several rodent holes observed at this location. (Fall 2022)

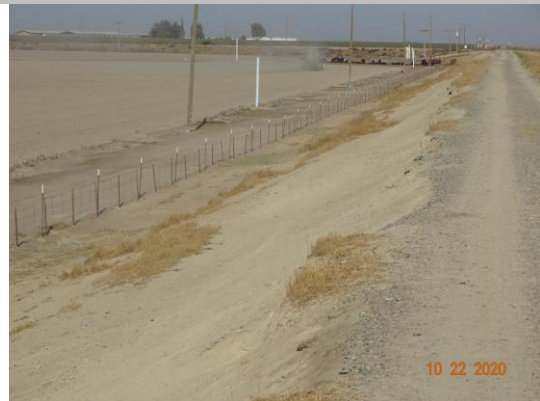
Photo 1 of 2 : FA_2024_NA0010_124_5_20240828_00006.jpg

LM Start	24.36	Rating **	U	Issue No.	5
LM End	25.01	Issue Type +	Ma	Location *	LS
Category	Earthen Levee			GPS Latitude/Longitude	
				Start	End
Item	Erosion / Livestock			37.073621°	37.066501°
				-120.521848°	-120.514193°
DWR ID	DWR_NA0010_06_s_2012_5				
Comment Code					
E4 : Repair the levee slope damaged by livestock and prevent large animal access.					
Inspector Comment					
Landside erosion and slope instability caused by livestock extends into levee crown. At the worst locations erosion extends 2.5 feet to 3 feet from the shoulder into the crown.

Looking downstream at erosion from livestock. (Fall 2020)

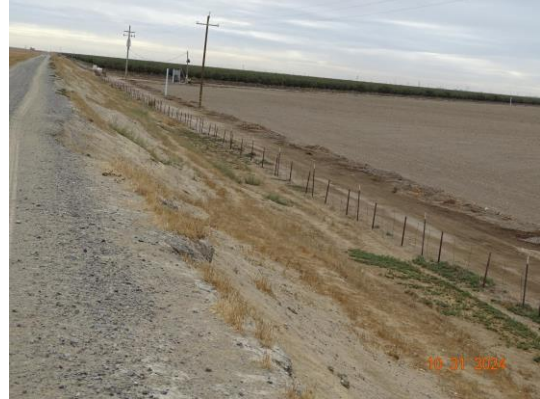
Photo 2 of 2 : FA_2024_NA0010_124_5_20241105_00162.jpg

Looking downstream at erosion from livestock on the landside slope.
(Fall 2024)

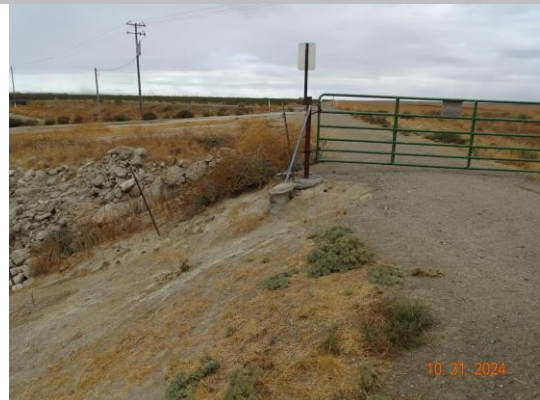
Photo 1 of 1 : FA_2024_NA0010_124_59_20241105_00163.jpg

LM Start	26.13	Rating **	M	Issue No.	59
LM End	26.13	Issue Type +	Ma	Location *	LS
Category	Earthen Levee			GPS Latitude/Longitude	
				Start	End
Item	Erosion / Livestock			37.054221 °	37.054221 °
				-120.500881 °	-120.500881 °
DWR ID	DWR_NA0010_06_f_2024_59				
Comment Code					
E4 : Repair the levee slope damaged by livestock and prevent large animal access.					
Inspector Comment

Erosion along the fence line on the landside slope. (Fall 2024)

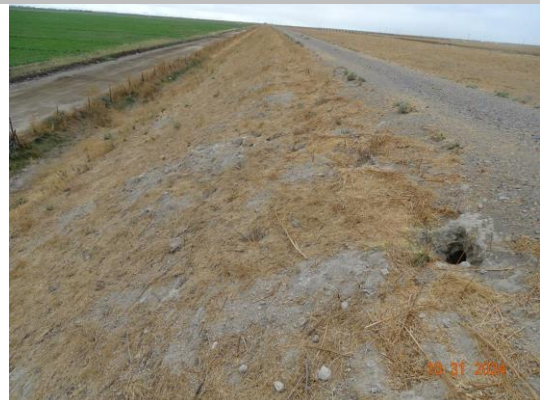
Photo 1 of 1 : FA_2024_NA0010_124_77_20241105_00164.jpg

LM Start	26.71	Rating **	M	Issue No.	77
LM End	26.71	Issue Type +	Ma	Location *	LS
Category	Earthen Levee			GPS Latitude/Longitude	
				Start	End
Item	Animal Control			37.048333 °	37.048333 °
				-120.493507 °	-120.493507 °
DWR ID	DWR_NA0010_06_f_2020_77				
Comment Code					
A3 : No rodents visible, but rodent burrows visible; need to backfill and compact or grout burrows.					
Inspector Comment					
Several rodent burrows on the landside slope.

View of rodent holes on the landside slope and shoulder. (Fall 2024)

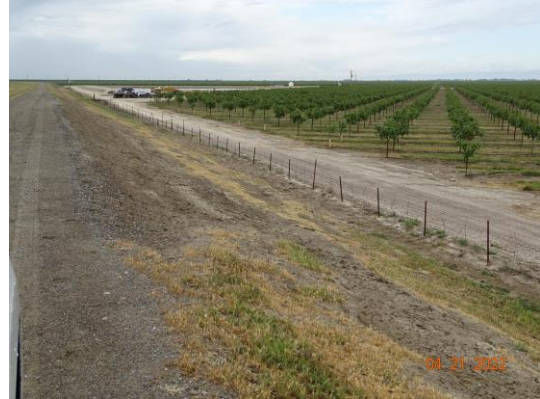
Photo 1 of 1 : FA_2024_NA0010_124_3_20240828_00005.jpg

LM Start	27.43	Rating **	U	Issue No.	3
LM End	28.09	Issue Type +	Ma	Location *	LS
Category	Earthen Levee			GPS Latitude/Longitude	
				Start	End
Item	Erosion / Livestock			37.036955 °	37.031694 °
				-120.484395 °	-120.479805 °
DWR ID	DWR_NA0010_06_s _ 2012_3				
Comment Code					
E4 : Repair the levee slope damaged by livestock and prevent large animal access.					
Inspector Comment					
Landside erosion and slope instability caused by livestock. Erosion greater than 3" in depth on landside slope. Levee crown has narrowed within this reach.

Looking south along landside slope. (Spring 2022)

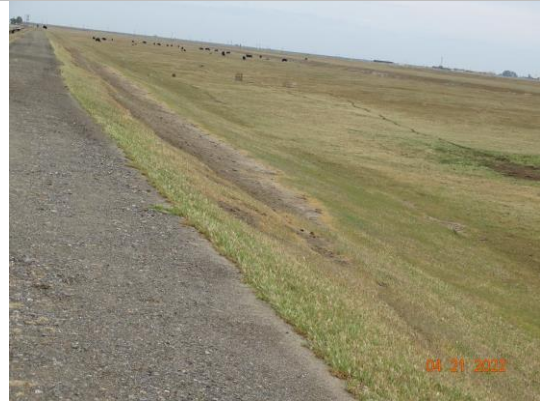
Photo 1 of 1 : FA_2024_NA0010_124_132_20240828_00054.jpg

LM Start	27.65	Rating **	M	Issue No.	132
LM End	27.93	Issue Type +	Ma	Location *	WS
Category	Earthen Levee			GPS Latitude/Longitude	
				Start	End
Item	Erosion / Livestock			37.036856 °	37.033468 °
				-120.484309 °	-120.481709 °
DWR ID	DWR_NA0010_06_s _ 2022_132				
Comment Code					
E4 : Repair the levee slope damaged by livestock and prevent large animal access.					
Inspector Comment

View of erosion on the waterside slope. (Spring 2022)

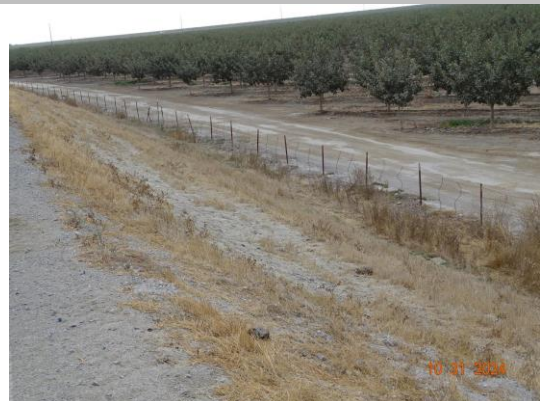
Photo 1 of 1 : FA_2024_NA0010_124_131_20241105_00165.jpg

LM Start	28.18	Rating **	M	Issue No.	131
LM End	28.18	Issue Type +	Ma	Location *	LS
Category	Earthen Levee			GPS Latitude/Longitude	
				Start	End
Item	Erosion / Livestock			37.030925 °	37.030925 °
				-120.478368 °	-120.478368 °
DWR ID	DWR_NA0010_06_s _ 2022_131				
Comment Code					
E4 : Repair the levee slope damaged by livestock and prevent large animal access.					
Inspector Comment

View of livestock damage on the landside slope. (Fall 2024)

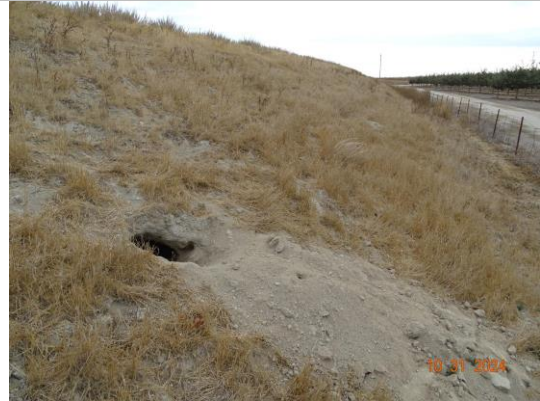
Photo 1 of 1 : FA_2024_NA0010_124_53_20241105_00166.jpg

LM Start	28.32	Rating **	U	Issue No.	53
LM End	28.32	Issue Type +	Ma	Location *	LS
Category	Earthen Levee			GPS Latitude/Longitude	
				Start	End
Item	Animal Control			37.030177 °	37.030177 °
				-120.476148 °	-120.476148 °
DWR ID	DWR_NA0010_06_f_2024_53				
Comment Code					
A3 : No rodents visible, but rodent burrows visible; need to backfill and compact or grout burrows.					
Inspector Comment					
Large burrow near the landside toe. Smaller burrows are located just upstream and downstream of the large burrow.

View of large rodent burrow on the landside slope. (Fall 2024)

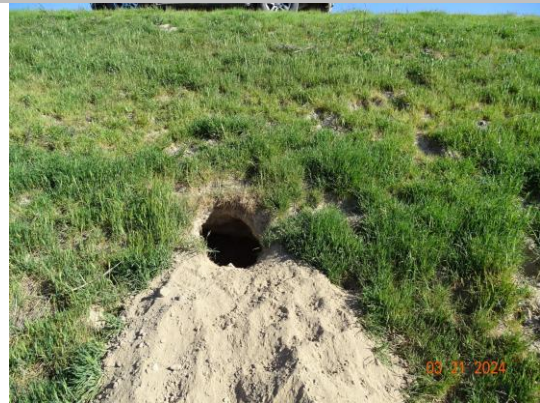
Photo 1 of 1 : FA_2024_NA0010_124_52_20240828_00009.jpg

LM Start	28.32	Rating **	M	Issue No.	52
LM End	28.32	Issue Type +	Ma	Location *	LS
Category	Earthen Levee			GPS Latitude/Longitude	
				Start	End
Item	Animal Control			37.030171 °	37.030171 °
				-120.476141 °	-120.476141 °
DWR ID	DWR_NA0010_06_s_2024_52				
Comment Code					
A3 : No rodents visible, but rodent burrows visible; need to backfill and compact or grout burrows.					
Inspector Comment

Large rodent hole observed near the landside hinge point. (Spring 2024)

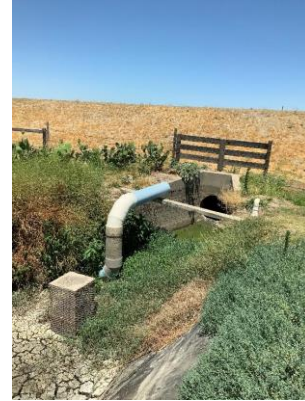
Photo 1 of 3 : UCIP_FA_2024_71146_103939.jpg

Comment Code					
Inspector Comment					
DS_ID:19881 FS_ID:71146 EP_NO: N/A Repair Type: Non-Urgent EVAL Issue: 4b, Safety Issue Crossing Status: Found UCIP Comments: 09/25/2024 DMP internal video inspection has found moderate pipe defects. Crossing will be monitored until funding becomes available for rehabilitation. (O. Yakimov - DWR UCIP) 06/24/2021 The record remains Non-Urgent. WS inlet had sediment build up in pipe; recommend removal. Build up of debris in CMP riser on WS slope; recommend removal. WS CMP riser is missing lid, causing safety hazard. LS pipe outlet had elevated water levels around the headwall and pipe, limited ability to inspect closely. Unidentified pipe has been installed off 15 feet from the toe of LS headwall; does not affect crossing. No permit was found authorizing this encroachment. CVFPB will need to review crossing to determine owner. The UCIP inspection was completed with GEI staff, H.Dunn. (P.Espinoza ? GEI) 04/10/2014 Dense vegetation limits the inspector's visibility to identify signs of pipe failure (leaks) along the slopes. Recommend removing vegetation along pipe alignment to conduct proper inspection of structure. (O. Magana - DWR UCIP) FIELD_STRUCT_DESC: 36-inch corrugated metal gravity irrigation pipe (CMP) through the levee, 12.4 feet below the crown. Slide gate in a 48-inch CMP riser unit on the waterside (WS) slope. Concrete U-shaped headwall on each end. Cobble pad on the landside (LS). [Additional Reference(s): DWR Levee Log, 2002, (HLM 29.34). USACE San Joaquin O&M Manual, Unit No. 601, Part No. 1, 1967, Amended in 1978, Revised 20 June 1985, (HLM 29.34). DWR As-Built Specification No. 64-01, Sheet No. 10, 6 November 1963, (HLM 29.34)]. FS Date: 6/24/2021 4:24:00 PM

LS view: Concrete headwall and slope from toe. Unidentified pipes near entrance of outlet pipe.

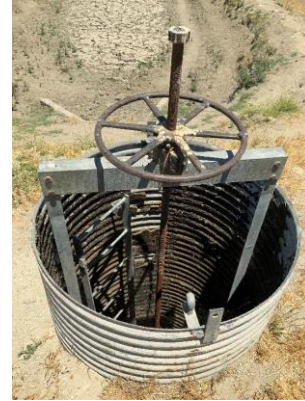
Photo 2 of 3 : UCIP_FA_2024_71146_103935.jpg

WS view: Close up of CMP riser with slide gate located on slope.

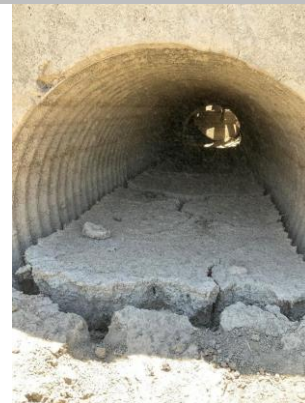
Photo 3 of 3 : UCIP_FA_2024_71146_103938.jpg

WS view: Inside of inlet pipe at toe.

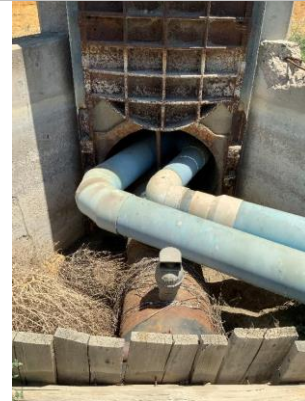
Photo 1 of 1 : UCIP_FA_2024_71147_103942.jpg

Comment Code					
Inspector Comment					
DS_ID:19882 FS_ID:71147 EP_NO: N/A Repair Type: Non-Urgent EVAL Issue: 10, Unauthorized Modification or Non-Compliant Permit Crossing Status: Found UCIP Comments: 06/24/2021 The record remains Non-Urgent. Altered crossing -- Two 12" plastic pipes going through LS outlet, recommend removing before flood season. No permit was found authorizing this encroachment. CVFPB will need to review crossing to determine owner. The UCIP inspection was completed with GEI staff, H.Dunn. (P.Espinoza ? GEI)04/10/2014 Altered crossing--steel pipe section on landward side and concrete pipe section on waterward side. Joints on waterward side separated. Need to contact owner to determine status. (O. Magana - DWR UCIP) FIELD_STRUCT_DESC: [Rodunder Siphon] 48-inch reinforced concrete pipe (RCP) irrigation siphon through the levee, 14.5 feet below the crown. Concrete U-shaped headwall on the outlet structure on the landside (LS) end. Slide gate mounted on the headwall. [Additional Reference(s): DWR Levee Log, 2002, (HLM 30.26). USACE San Joaquin O&M Manual, Unit No. 601, Part No. 1, 1967, Amended in 1978, Revised 20 June 1985, (HLM 30.27). DWR As-Built Specification No. 64-01, Sheet No. 11, 6 November 1963, (HLM 30.27)]. FS Date: 6/24/2021 10:15:00 AM

LS view: Closeup of slide gate and unauthorized 12" pipes going through outlet pipe at toe, 1 of 2 photos.
