Flood Control Project Maintenance Levee Inspections

Fall 2024 Levee Maintenance Deficiency Summary Report

San Joaquin River Basin

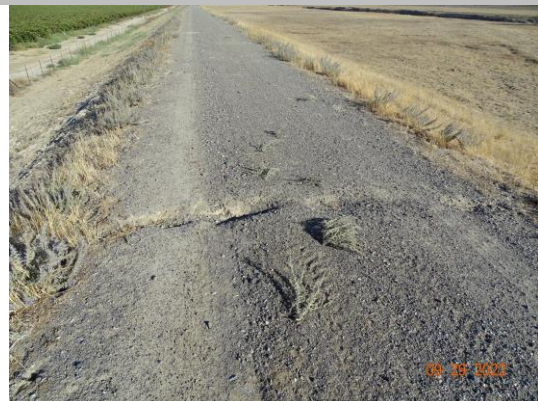
Photo 1 of 1 : FA_2024_NA0010_124_139_20240828_00058.jpg

LM Start	30.79	Rating **	M	Issue No.	139
LM End	30.79	Issue Type +	Ma	Location *	CR
Category	Earthen Levee			GPS Latitude/Longitude	
				Start	End
Item	Animal Control			37.021804 °	37.021804 °
				-120.437703 °	-120.437703 °
DWR ID	DWR_NA0010_06_f_2022_139				
Comment Code					
A3 : No rodents visible, but rodent burrows visible; need to backfill and compact or grout burrows.					
Inspector Comment					
Collapsed rodent burrow has created a few depressions in the crown at this location.

Depression in the levee crown. (Fall 2022)

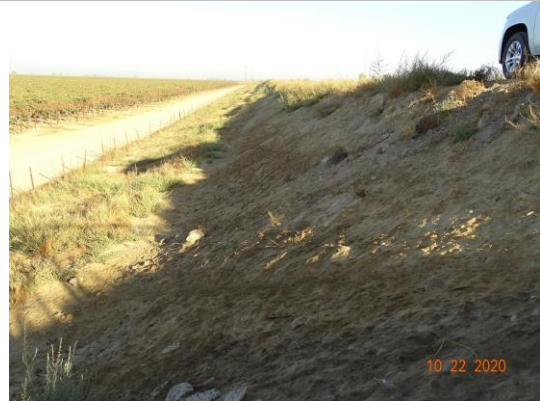
Photo 1 of 1 : FA_2024_NA0010_124_1207_20240828_00071.jpg

LM Start	30.81	Rating **	M	Issue No.	1207
LM End	31.06	Issue Type +	Ma	Location *	LS
Category	Earthen Levee			GPS Latitude/Longitude	
				Start	End
Item	Erosion / Livestock			37.021615 °	37.018428 °
				-120.437587 °	-120.435378 °
DWR ID	DWR_NA0010_06_s _ 2015_1207				
Comment Code					
E4 : Repair the levee slope damaged by livestock and prevent large animal access.					
Inspector Comment					
Landside erosion greater than 1" in depth and greater than 3" in length. Erosion is caused by livestock traffic.

Looking upstream at livestock damage to the landside slope. (Fall 2020)

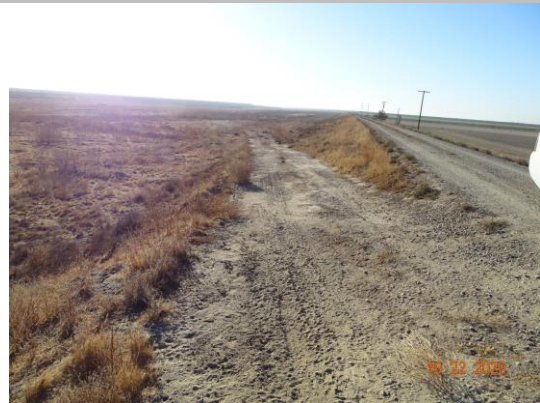
Photo 1 of 1 : FA_2024_NA0010_124_80_20240828_00023.jpg

LM Start	31.10	Rating **	M	Issue No.	80
LM End	31.10	Issue Type +	En	Location *	WS
Category	Earthen Levee			GPS Latitude/Longitude	
				Start	End
Item	Encroachments			37.017907 °	37.017907 °
				-120.434970 °	-120.434970 °
DWR ID	DWR_NA0010_06_s _ 2017_80				
Comment Code					
RA : Ramp					
Inspector Comment					
Farmer installed ramp on waterside slope.

Looking upstream at ramp on the waterside slope. (Fall 2020)

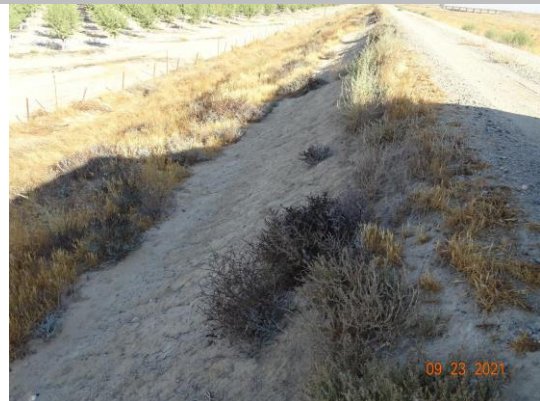
Photo 1 of 1 : FA_2024_NA0010_124_108_20240828_00037.jpg

LM Start	31.50	Rating **	M	Issue No.	108
LM End	31.70	Issue Type +	Ma	Location *	LS
Category	Earthen Levee			GPS Latitude/Longitude	
				Start	End
Item	Erosion / Livestock			37.012830 °	37.010335 °
				-120.431523 °	-120.429817 °
DWR ID	DWR_NA0010_06_f _ 2021_108				
Comment Code					
E4 : Repair the levee slope damaged by livestock and prevent large animal access.					
Inspector Comment

View of the landside slope looking downstream. (Fall 2021)

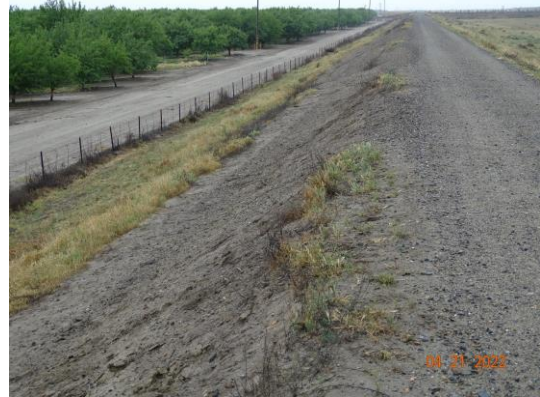
Photo 1 of 1 : FA_2024_NA0010_124_129_20240828_00052.jpg

LM Start	32.37	Rating **	U	Issue No.	129
LM End	32.88	Issue Type +	Ma	Location *	LS
Category	Earthen Levee			GPS Latitude/Longitude	
				Start	End
Item	Erosion / Livestock			37.003251 °	36.997745 °
				-120.421556 °	-120.415197 °
DWR ID	DWR_NA0010_06_s_2022_129				
Comment Code					
E4 : Repair the levee slope damaged by livestock and prevent large animal access.					
Inspector Comment					
Slope damage from livestock. Damage is beginning to erode into levee crown.

Erosion from livestock activity along the landside slope. (Spring 2022)

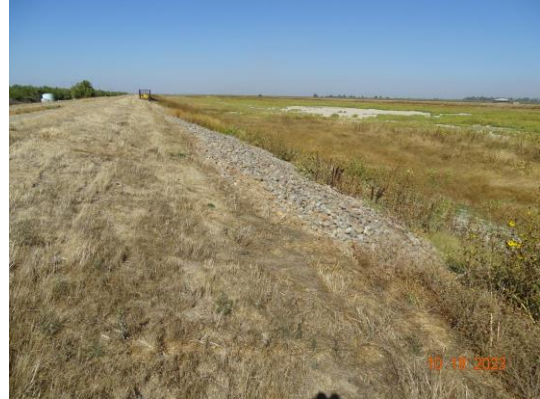
Photo 1 of 1 : FA_2024_NA0010_124_87_20240828_00027.jpg

LM Start	32.92	Rating **	A/W	Issue No.	87
LM End	33.14	Issue Type +	Ma	Location *	WS
Category	Earthen Levee			GPS Latitude/Longitude	
				Start	End
Item	Riprap Revetments			36.997386 °	36.994944 °
				-120.414850 °	-120.412131 °
DWR ID	DWR_NA0010_06_f _ 2023_87				
Comment Code					
RR : Riprap Revetments					
Inspector Comment

View of revetment placed on the waterside slope. (Fall 2023)

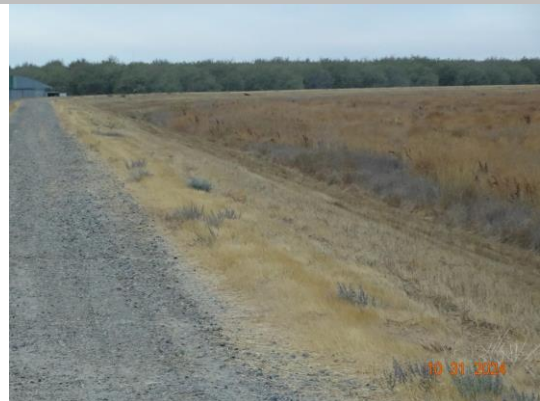
Photo 1 of 1 : FA_2024_NA0010_124_49_20241105_00167.jpg

LM Start	35.31	Rating **	A	Issue No.	49
LM End	35.31	Issue Type +	Ma	Location *	WS
Category	Earthen Levee			GPS Latitude/Longitude	
				Start	End
Item	Vegetation			36.974622 °	36.974622 °
				-120.383870 °	-120.383870 °
DWR ID	DWR_NA0010_06_f_2024_49				
Comment Code					
V1 : Control annual grass and weeds on the levee slopes and easements.					
Inspector Comment

View of vegetation management on the waterside slope. (Fall 2024)

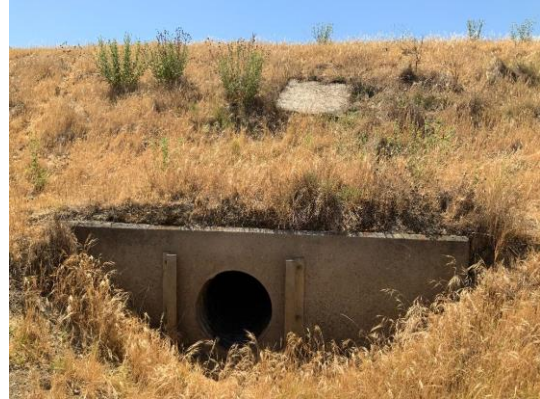
Photo 1 of 3 : UCIP_FA_2024_84927_99441.jpg

Comment Code						
Inspector Comment						
DS_ID:19892 FS_ID:84927 EP_NO: N/A Repair Type: No Action Needed EVAL Issue: Crossing Status: Found UCIP Comments: 10/04/2024 Record updated from Non-Urgent to No Action Needed. Removed code 12b since pipe is drainage and record source is Levee Log and O&M. (M. Thao - DWR UCIP) 6/02/2021 Record remains Non-Urgent. DWR DMP internal inspection has not found pipe integrity issues. LOF of crossing is less or equal to 4.0. Recommend next video inspection in 5 years. No permit was found authorizing this encroachment. CVFPB will need to review crossing to determine owner. The UCIP inspection was completed with GEI staff, P. Espinoza. (H. Dunn ? GEI) 07/20/2016 Inlet blocked off by wooden board. Dense vegetation limits the inspector's visibility to identify signs of pipe failure (leaks) along WS and LS. Crossing downgraded from Urgent to Non-Urgent. (O. Magana - DWR UCIP) 04/15/2014 Flapgate partially blocked by soil buildup at WS toe. (W. Wylie - DWR UCIP) FIELD_STRUCT_DESC: 24-inch corrugated metal gravity drainage pipe (CMP) through the levee, 10.8 feet below the crown. Flap gate on the waterside (WS) end. Concrete headwall on the landside (LS) end. Concrete U-shaped headwall on the WS end. [Additional Reference(s): DWR Levee Log, 2002, (HLM 0.08). USACE San Joaquin O&M Manual, Unit No. 601, Part No. 1, 1967, Amended in 1978, Revised 20 June 1985, (HLM 0.07). DWR As-Built Specification No. 63-25, Sheet No. 11, 9 May 1963, (HLM 0.07)]. FS Date: 6/2/2021

LS view: Slope and headwall at toe.

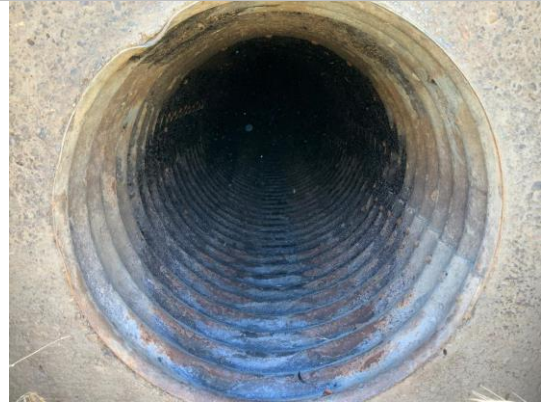
Photo 2 of 3 : UCIP_FA_2024_84927_99442.jpg

LS view: Close up of pipe inlet at toe.

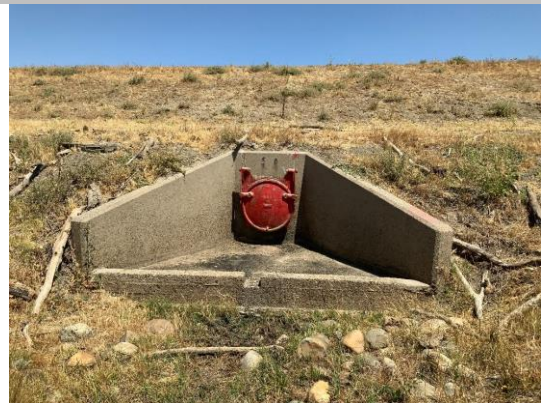
Photo 3 of 3 : UCIP_FA_2024_84927_99438.jpg

WS view: Slope, headwall, and flapgate at toe.

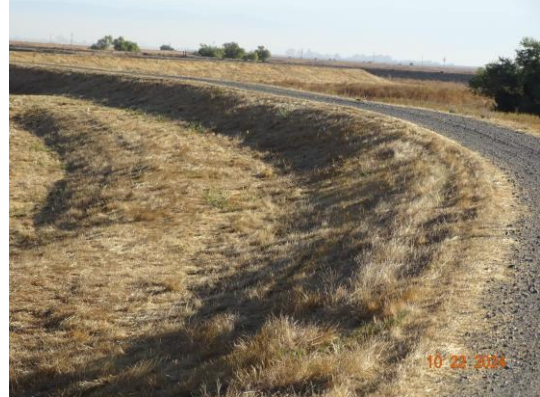
Photo 1 of 1 : FA_2024_NA0010_125_24_20241106_00046.jpg

LM Start	0.14	Rating **	A	Issue No.	24
LM End	0.14	Issue Type +	Ma	Location *	LS
Category	Earthen Levee			GPS Latitude/Longitude	
				Start	End
Item	Vegetation			37.256198 °	37.256198 °
				-120.770014 °	-120.770014 °
DWR ID	DWR_NA0010_07_f _ 2024_24				
Comment Code					
V1 : Control annual grass and weeds on the levee slopes and easements.					
Inspector Comment					
The annual vegetation is well maintained.

View of vegetation management on the landside slope. (Fall 2024)

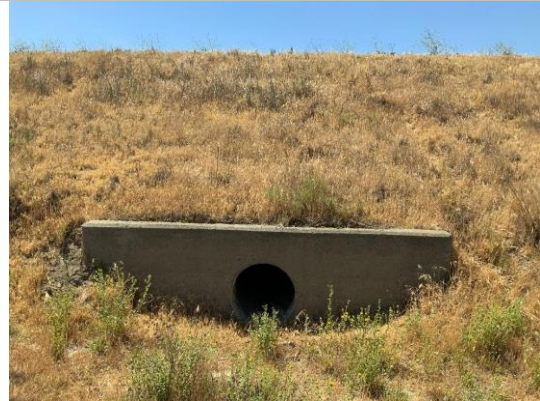
Photo 1 of 3 : UCIP_FA_2024_84928_99448.jpg

Comment Code					
Inspector Comment					
DS_ID:19893 FS_ID:84928 EP_NO: N/A Repair Type: No Action Needed EVAL Issue: Crossing Status: Found UCIP Comments: 10/04/2024 Record updated from Non-Urgent to No Action Needed. Removed code 12b since pipe is drainage and record source is Levee Log and O&M. (M. Thao - DWR UCIP 06/02/2021 The record has been upgraded from No Action Needed to Non-Urgent. DWR DMP internal inspection has not found pipe integrity issues. LOF of crossing is less or equal to 4.0. Recommend next video inspection in 5 years. No permit was found authorizing this encroachment. CVFPB will need to review crossing to determine owner. The UCIP inspection was completed with GEI staff, P. Espinoza. (H. Dunn ? GEI) FIELD_STRUCT_DESC: 24-inch corrugated metal gravity drainage pipe (CMP) through the levee, 11.1 feet below the crown. Flap gate on the waterside (WS) end. Concrete headwall on the landside (LS) end. Concrete U-shaped headwall on the WS end. [Additional Reference(s): DWR Levee Log, 2002, (HLM 0.34). USACE San Joaquin O&M Manual, Unit No. 601, Part No. 1, 1967, Amended in 1978, Revised 20 June 1985, (HLM 0.33). DWR As-Built Specification No. 63-25, Sheet No. 11, 9 May 1963, (HLM 0.33)]. FS Date: 6/2/2021

LS view: Slope and headwall at toe.

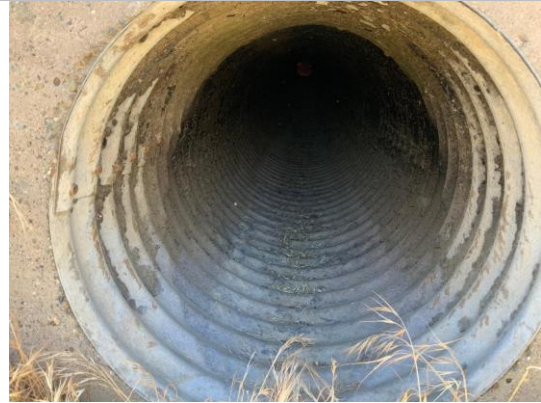
Photo 2 of 3 : UCIP_FA_2024_84928_99443.jpg

LS view: Close up of pipe inlet at toe.

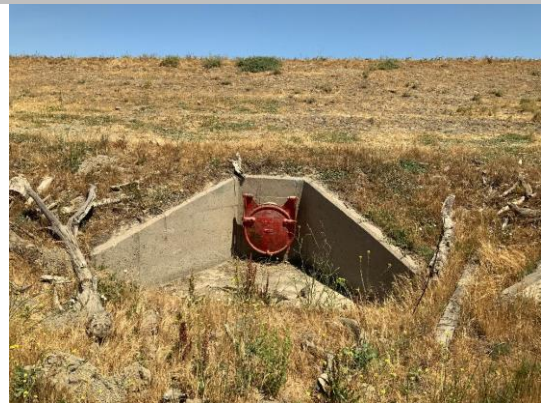
Photo 3 of 3 : UCIP_FA_2024_84928_99445.jpg

WS view: Slope, headwall, and flapgate at toe.

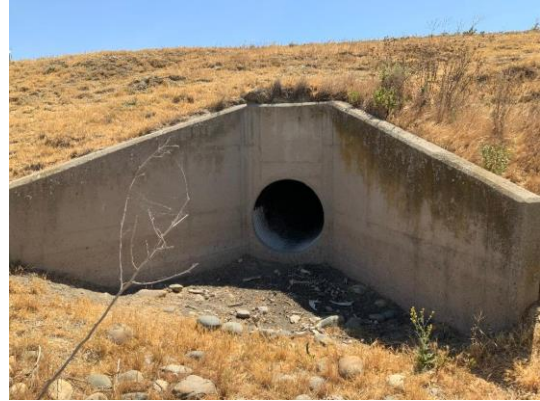
Photo 1 of 3 : UCIP_FA_2024_71167_99450.jpg

DS_ID:19894
FS_ID:71167
EP_NO: N/A
Repair Type: Non-Urgent
EVAL Issue: 4b, Safety Issue
Crossing Status: Found
UCIP Comments: 06/2/2021 Record remains Non-Urgent. No cover over the WS metal riser. There is debris and wood pallets within the riser that may prevent the ability for the slidegate to be opened or water to flow through, recommend cleaning out. DWR DMP internal inspection has not found pipe integrity issues. LOF of crossing is less or equal to 4.0. Recommend next video inspection in 5 years. No permit was found authorizing this encroachment. CVFPB will need to review crossing to determine owner. The UCIP inspection was completed with GEI staff, P. Espinoza. (H. Dunn ? GEI)04/15/2014 Slide gate not operable, but left in closed position. Need to reinstall covers over slide gate standpipe. (W. Wylie - DWR UCIP)
FIELD_STRUCT_DESC: 36-inch corrugated metal gravity drainage pipe (CMP) through the levee, 9.7 feet below the crown. Slide gate in a 48-inch CMP riser unit on the landside (LS) slope. Concrete U-shaped headwall on the LS end. Inlet channel cobble revetted. Dilapidated wooden pier on the waterside (WS). WS slope and outlet ditch cobble revetted. [Additional Reference(s): DWR Levee Log, 2002, (HLM 0.49). USACE San Joaquin O&M Manual, Unit No. 601, Part No. 1, 1967, Amended in 1978, Revised 20 June 1985, (HLM 0.49). DWR As-Built Specification No. 63-25, Sheet No. 11, 9 May 1963, (HLM 0.49)].

LS view: Slope and headwall at toe.

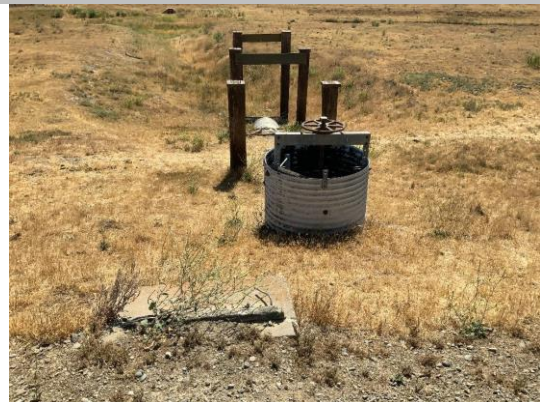
Photo 2 of 3 : UCIP_FA_2024_71167_99453.jpg

WS view: Slope with metal riser and slidegate from crown.

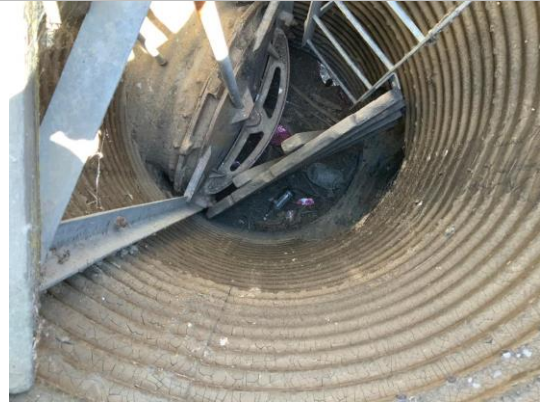
Photo 3 of 3 : UCIP_FA_2024_71167_99454.jpg

WS view: Close up of inside metal riser, wood pallets in the way.

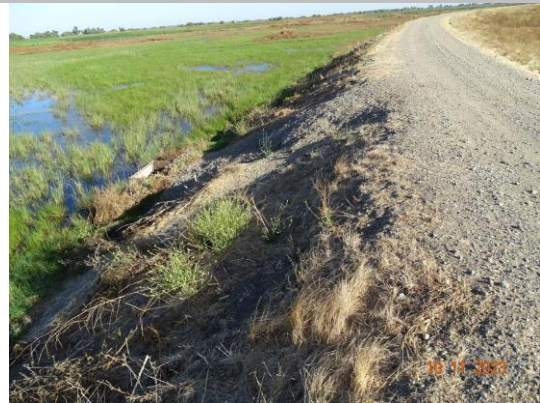
Photo 1 of 1 : FA_2024_NA0010_125_18_20240828_00006.jpg

LM Start	0.53	Rating **	A/W	Issue No.	18
LM End	0.53	Issue Type +	Ma	Location *	LS
Category	Earthen Levee			GPS Latitude/Longitude	
				Start	End
Item	Erosion / Livestock			37.259097 °	37.259097 °
				-120.764846 °	-120.764846 °
DWR ID	DWR_NA0010_07_f_2018_18				
Comment Code					
E4 : Repair the levee slope damaged by livestock and prevent large animal access.					
Inspector Comment					
There is livestock damage to the landside slope but the levee integrity is not compromised. Continue to monitor.

View of damage from livestock looking upstream. (Fall 2023)

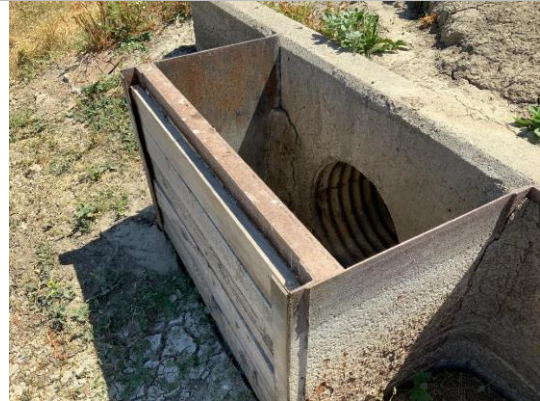
Photo 1 of 3 : UCIP_FA_2024_72517_99457.jpg

Comment Code						
Inspector Comment						
DS_ID:19895 FS_ID:72517 EP_NO: N/A Repair Type: Urgent EVAL Issue: 3a, Flood Risk Crossing Status: Found UCIP Comments: 09/25/2024 DMP internal video inspection has found moderate pipe defects. Crossing will be monitored until funding becomes available for rehabilitation. (O. Yakimov - DWR UCIP) 05/04/2023 Enforcement Case No. 2023-15633 was issued to this crossing for unauthorized modifications that include: Unauthorized removal of flood control flapgate on the waterside of the levee, adding flashboards and metal brackets to landside and waterside concrete headwalls. (O.Yakimov - DWR UCIP) 06/2/2021 The record has been upgraded from No Action Needed to Urgent. There are plywood barriers on both WS and LS pipe ends, but no flapgate on either, and flapgate removed on WS. DWR DMP internal inspection has not found pipe integrity issues. LOF of crossing is less or equal to 4.0. Recommend next video inspection in 5 years. The UCIP inspection was completed with GEI staff, P. Espinoza. (H. Dunn ? GEI) FIELD_STRUCT_DESC: 24-inch corrugated metal gravity drainage pipe (CMP) through the levee, 9.0 feet below the crown. Flap gate on the waterside (WS) end. Concrete headwall with a wooden weir at the inlet on the landside (LS) toe. Concrete U-shaped headwall on the WS toe. [Additional Reference(s): DWR Levee Log, 2002, (HLM 0.53). USACE San Joaquin O&M Manual, Unit No. 601, Part No. 1, 1967, Amended in 1978, Revised 20 June 1985, (HLM 0.53). DWR As-Built Specification No. 63-25, Sheet No. 11, 9 May 1963, (HLM 0.53)]. FS Date: 6/2/2021

LS view: Close up of plywood barrier at toe.

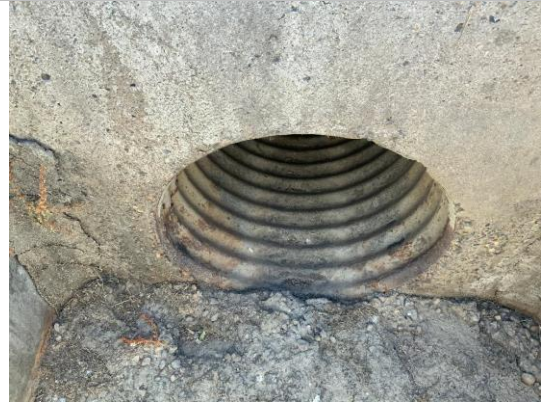
Photo 2 of 3 : UCIP_FA_2024_72517_99458.jpg

LS view: Close up of pipe inlet at toe.

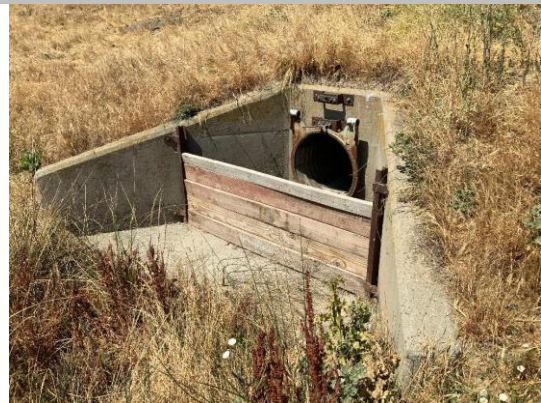
Photo 3 of 3 : UCIP_FA_2024_72517_99463.jpg

WS view: Close up of plywood barrier with no flapgate.

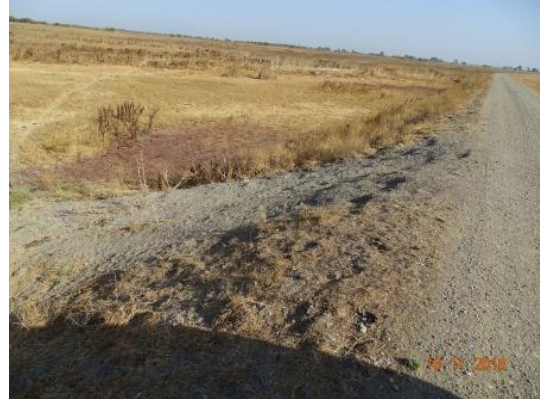
Photo 1 of 1 : FA_2024_NA0010_125_19_20240828_00007.jpg

LM Start	0.70	Rating **	A/W	Issue No.	19
LM End	0.70	Issue Type +	Ma	Location *	LS
Category	Earthen Levee			GPS Latitude/Longitude	
				Start	End
Item	Erosion / Livestock			37.261337 °	37.261337 °
				-120.763303 °	-120.763303 °
DWR ID	DWR_NA0010_07_f_2018_19				
Comment Code					
E4 : Repair the levee slope damaged by livestock and prevent large animal access.					
Inspector Comment					
There is livestock damage to the landside slope but the levee integrity is not compromised. Continue to monitor.

Damage to landside slope from livestock. (Fall 2018)

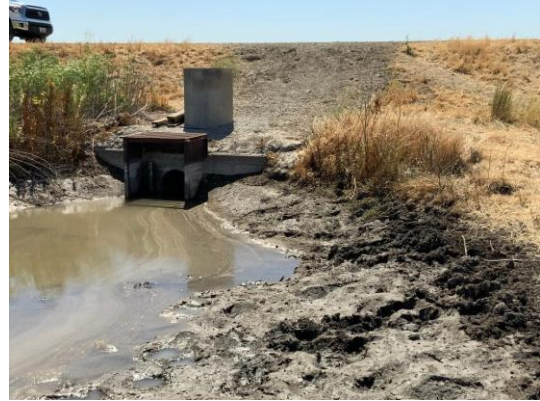
Photo 1 of 3 : UCIP_FA_2024_71169_99465.jpg

Comment Code						
Inspector Comment						
DS_ID:19896 FS_ID:71169 EP_NO: N/A Repair Type: Non-Urgent EVAL Issue: 5, Pipe Damage Crossing Status: Found UCIP Comments: 05/04/2023 Enforcement Case No. 2023-15633 was issued to this crossing for unauthorized modifications that include: Cutting out the pipe to install a concrete riser with water meter inside, adding flashboards and metal brackets to landside and waterside concrete headwalls. (O.Yakimov - DWR UCIP) 06/2/2021 Record remains Non-Urgent. Limited inspection due to water flowing through the pipe during inspection. At the time of inspection, the wooden flashboards were not in place on the LS end. DMP internal video inspection has found moderate pipe defects. Crossing will be monitored until funding becomes available for rehabilitation. The UCIP inspection was completed with GEI staff, P. Espinoza. (H. Dunn ? GEI) 04/15/2014 Need to contact owner. Heavy sediment buildup at inlet due to animal activity should be cleared. (W. Wylie - DWR UCIP) FIELD_STRUCT_DESC: 24-inch corrugated metal gravity drainage pipe (CMP) through the levee, 9.8 feet below the crown. Flap gate on the waterside (WS) end. Wooden weir on a concrete headwall at the landside (LS) toe. 36-inch concrete riser unit at the LS toe. Concrete U-shaped headwall on the WS end. Concrete standpipe on the LS. [Additional Reference(s): DWR Levee Log, 2002, (HLM 0.86). USACE San Joaquin O&M Manual, Unit No. 601, Part No. 1, 1967, Amended in 1978, Revised 20 June 1985, (HLM 0.85). DWR As-Built Specification No. 63-25, Sheet No. 11, 9 May 1963, (HLM 0.85)]. FS Date: 6/2/2021

LS view: Slope and riser visible at toe.

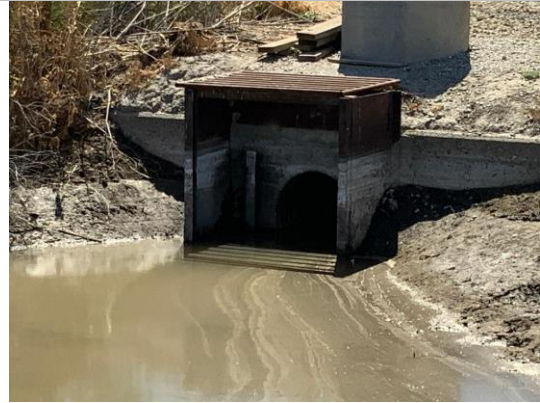
Photo 2 of 3 : UCIP_FA_2024_71169_99466.jpg

LS view: Close up of pipe inlet at toe.

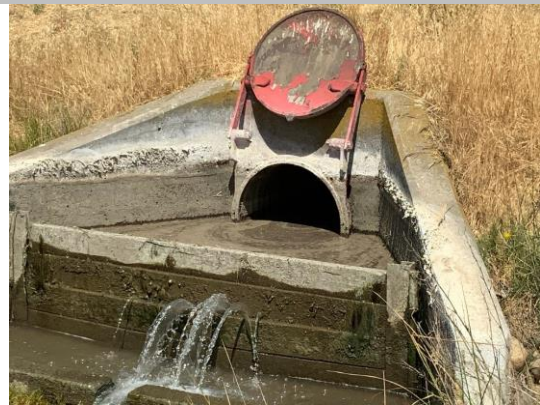
Photo 3 of 3 : UCIP_FA_2024_71169_99470.jpg

WS view: Close up of flapgate at toe.

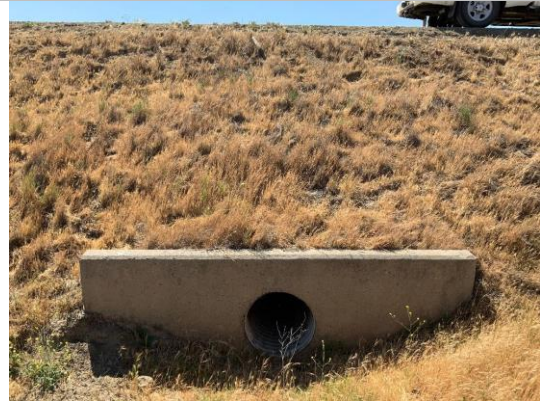
Photo 1 of 3 : UCIP_FA_2024_71170_99472.jpg

Comment Code						
Inspector Comment						
DS_ID:19897 FS_ID:71170 EP_NO: N/A Repair Type: Non-Urgent EVAL Issue: Crossing Status: Found UCIP Comments: 06/2/2021 The record has been upgraded from No Action Needed to Non-Urgent. DWR DMP internal inspection has not found pipe integrity issues. LOF of crossing is less or equal to 4.0. Recommend next video inspection in 5 years. No permit was found authorizing this encroachment. CVFPB will need to review crossing to determine owner. The UCIP inspection was completed with GEI staff, P. Espinoza. (H. Dunn ? GEI) FIELD_STRUCT_DESC: 24-inch corrugated metal gravity drainage pipe (CMP) through the levee, 11.5 feet below the crown. Flap gate on the waterside (WS) end. Concrete headwall on the landside (LS) end. Concrete U-shaped headwall on the WS end. [Additional Reference(s): DWR Levee Log, 2002, (HLM 0.94). USACE San Joaquin O&M Manual, Unit No. 601, Part No. 1, 1967, Amended in 1978, Revised 20 June 1985, (HLM 0.94). DWR As-Built Specification No. 63-25, Sheet No. 11, 9 May 1963, (HLM 0.94)]. FS Date: 6/2/2021

LS view: Slope and headwall at toe.

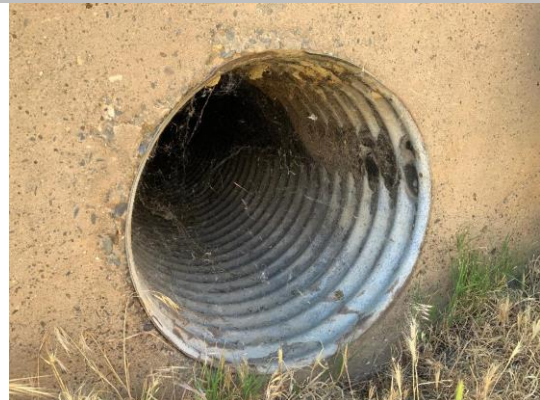
Photo 2 of 3 : UCIP_FA_2024_71170_99473.jpg

LS view: Close up of pipe inlet.

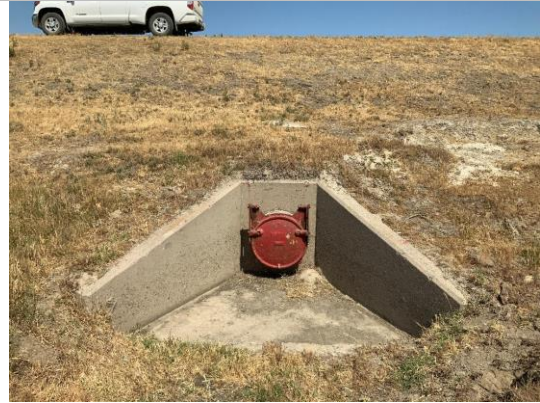
Photo 3 of 3 : UCIP_FA_2024_71170_99476.jpg

WS view: Slope, headwall, and flapgate at toe.

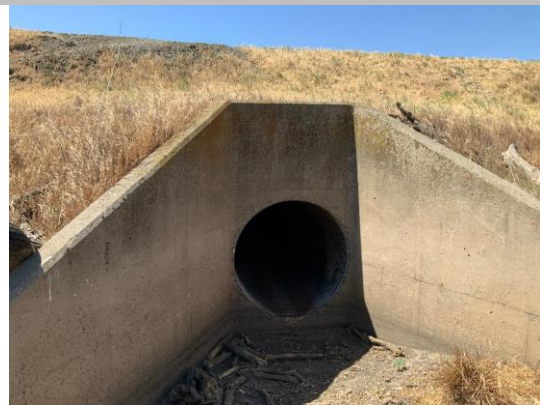
Photo 1 of 3 : UCIP_FA_2024_81167_99483.jpg

DS_ID:19898
FS_ID:81167
EP_NO: N/A
Repair Type: No Action Needed
EVAL Issue:
Crossing Status: Found
UCIP Comments: 09/25/2023 DMP internal video inspection has found none or minor pipe defects. Recommend next video inspection in 5 years. (J. Taylor - DWR UCIP 6/2/2021 The record has been upgraded from No Action Needed to Non-Urgent. No permit was found authorizing this encroachment. CVFPB will need to review crossing to determine owner. The UCIP inspection was completed with GEI staff, P. Espinoza. (H. Dunn ? GEI)
FIELD_STRUCT_DESC: 48-inch CIPP lined corrugated metal gravity drainage pipe (CMP) through the levee, 14.6 feet below the crown. Flap gate on the waterside (WS) end. Concrete U-shaped headwall on each end. [Additional Reference(s): DWR Levee Log, 2002, (HLM 1.17). USACE San Joaquin O&M Manual, Unit No. 601, Part No. 1, 1967, Amended in 1978, Revised 20 June 1985, (HLM 1.17). DWR As-Built Specification No. 63-25, Sheet No. 11, 9 May 1963, (HLM 1.17)].

LS view: Slope and headwall at toe.

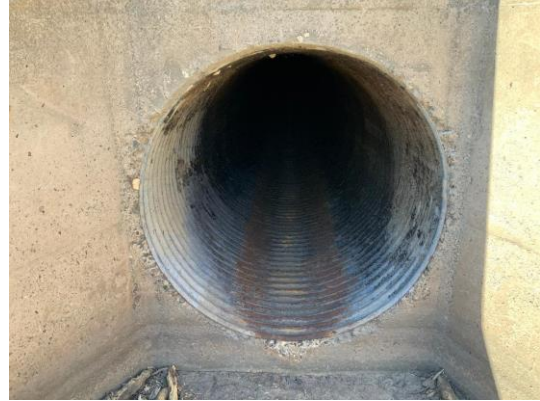
Photo 2 of 3 : UCIP_FA_2024_81167_99484.jpg

LS view: Close up of pipe inlet at toe.

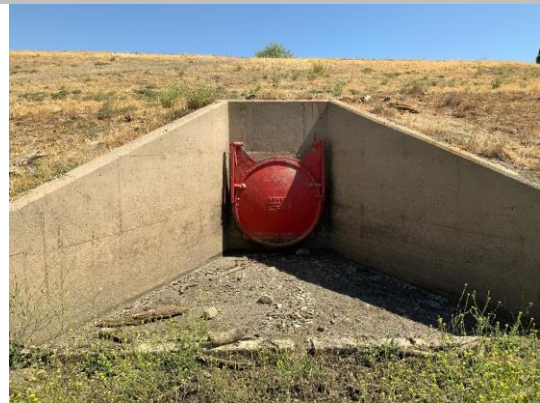
Photo 3 of 3 : UCIP_FA_2024_81167_99479.jpg

WS view: Slope, headwall, and flapgate at toe.

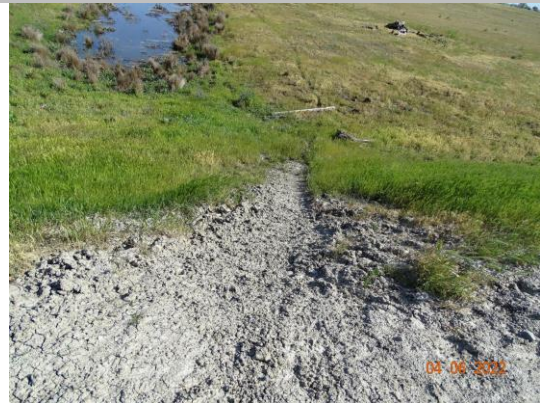
Photo 1 of 1 : FA_2024_NA0010_125_25_20240828_00011.jpg

LM Start	1.24	Rating **	A/W	Issue No.	25
LM End	1.24	Issue Type +	Ma	Location *	LS
Category	Earthen Levee			GPS Latitude/Longitude	
				Start	End
Item	Erosion / Livestock			37.264365 °	37.264365 °
				-120.755358 °	-120.755358 °
DWR ID	DWR_NA0010_07_s_2022_25				
Comment Code					
E4 : Repair the levee slope damaged by livestock and prevent large animal access.					
Inspector Comment

Looking down the landside slope at erosion from livestock traffic. (Spring 2022)

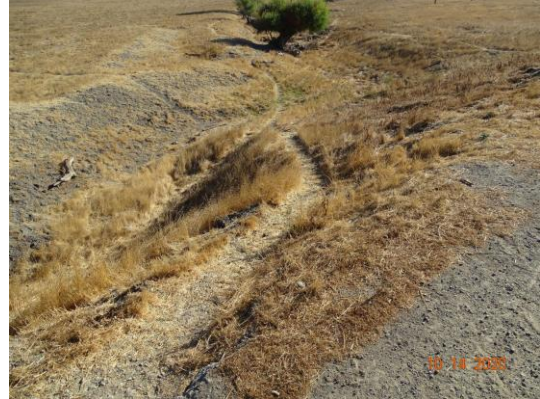
Photo 1 of 1 : FA_2024_NA0010_125_16_20240828_00004.jpg

LM Start	1.49	Rating **	A/W	Issue No.	16
LM End	1.49	Issue Type +	Ma	Location *	LS
Category	Earthen Levee			GPS Latitude/Longitude	
				Start	End
Item	Erosion / Livestock			37.263999 °	37.263999 °
				-120.750854 °	-120.750854 °
DWR ID	DWR_NA0010_07_f _ 2017_16				
Comment Code					
E4 : Repair the levee slope damaged by livestock and prevent large animal access.					
Inspector Comment					
Monitor the slope damaged by animal traffic.

Cattle trail on the landside slope. (Fall 2020)

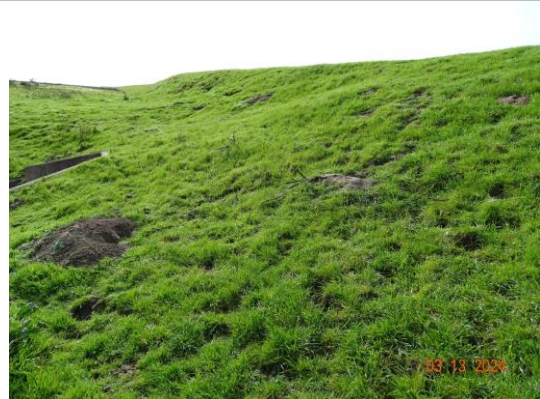
Photo 1 of 1 : FA_2024_NA0010_125_6_20240828_00001.jpg

LM Start	1.50	Rating **	M	Issue No.	6
LM End	1.51	Issue Type +	Ma	Location *	LS
Category	Earthen Levee			GPS Latitude/Longitude	
				Start	End
Item	Animal Control			37.263955 °	37.263885 °
				-120.750751 °	-120.750527 °
DWR ID	DWR_NA0010_07_s_2014_6				
Comment Code					
A1 : Exterminate rodents and backfill and compact or grout burrows.					
Inspector Comment

View of rodent holes on the landside slope. (Spring 2024)

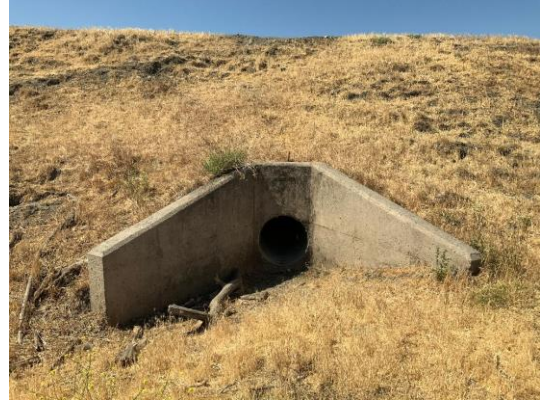
Photo 1 of 3 : UCIP_FA_2024_71172_99486.jpg

Comment Code					
Inspector Comment					
DS_ID:19902 FS_ID:71172 EP_NO: N/A Repair Type: Non-Urgent EVAL Issue: Crossing Status: Found UCIP Comments: 06/2/2021 The record has been upgraded from No Action Needed to Non-Urgent. DWR DMP internal inspection has not found pipe integrity issues. LOF of crossing is less or equal to 4.0. Recommend next video inspection in 5 years. No permit was found authorizing this encroachment. CVFPB will need to review crossing to determine owner. The UCIP inspection was completed with GEI staff, P. Espinoza. (H. Dunn ? GEI) FIELD_STRUCT_DESC: 24-inch corrugated metal gravity drainage pipe (CMP) through the levee, 14.0 feet below the crown. Flap gate on the waterside (WS) end. Concrete U-shaped headwall on each end. [Additional Reference(s): DWR Levee Log, 2002, (HLM 1.51). USACE San Joaquin O&M Manual, Unit No. 601, Part No. 1, 1967, Amended in 1978, Revised 20 June 1985, (HLM 1.51). DWR As-Built Specification No. 63-25, Sheet No. 12, 9 May 1963, (HLM 1.51)]. FS Date: 6/2/2021

LS view: Slope and headwall at toe.

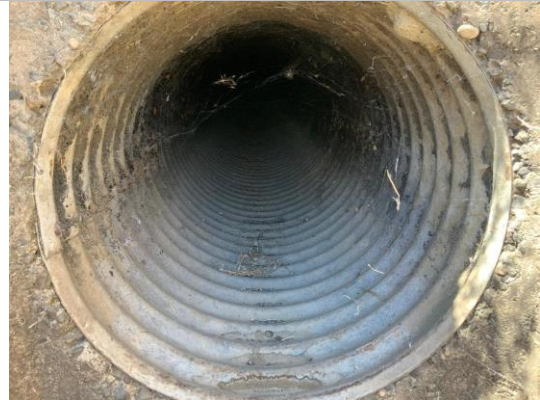
Photo 2 of 3 : UCIP_FA_2024_71172_99487.jpg

LS view: Close up of pipe inlet at toe.

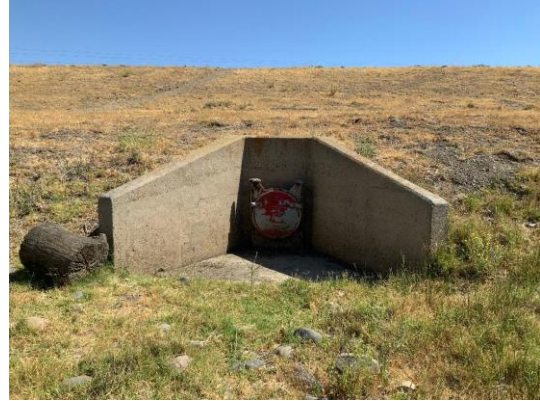
Photo 3 of 3 : UCIP_FA_2024_71172_99489.jpg

WS view: Slope, headwall, and flapgate at toe.

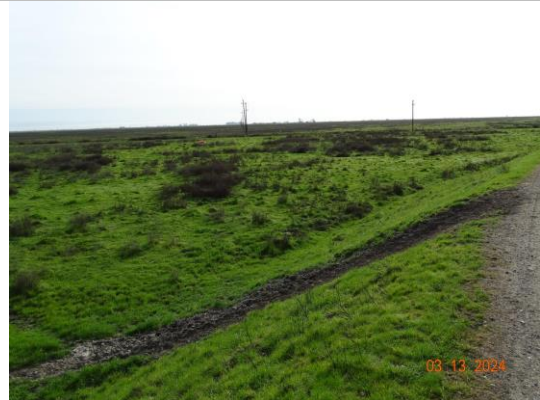
Photo 1 of 1 : FA_2024_NA0010_125_21_20240828_00008.jpg

LM Start	1.90	Rating **	M	Issue No.	21
LM End	1.90	Issue Type +	Ma	Location *	LS
Category	Earthen Levee			GPS Latitude/Longitude	
				Start	End
Item	Erosion / Livestock			37.261379 °	37.261379 °
				-120.744228 °	-120.744228 °
DWR ID	DWR_NA0010_07_f_2018_21				
Comment Code					
E4 : Repair the levee slope damaged by livestock and prevent large animal access.					
Inspector Comment

View of damage to the landside slope. (Spring 2024)

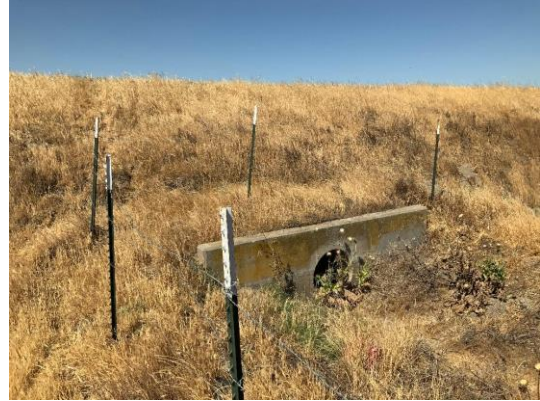
Photo 1 of 3 : UCIP_FA_2024_71173_99499.jpg

DS_ID:19899
FS_ID:71173
EP_NO: N/A
Repair Type: Non-Urgent
EVAL Issue:
Crossing Status: Found
UCIP Comments: 06/2/2021 The record has been upgraded from No Action Needed to Non-Urgent. LS pipe end surrounded by barbed wire, could not inspect closely. Metal pipe and plastic riser with flowmeter off the LS toe. DWR DMP internal inspection has not found pipe integrity issues. LOF of crossing is less or equal to 4.0. Recommend next video inspection in 5 years. No permit was found authorizing this encroachment. CVFPB will need to review crossing to determine owner. The UCIP inspection was completed with GEI staff, P. Espinoza. (H. Dunn ? GEI)
FIELD_STRUCT_DESC: 24-inch corrugated metal gravity drainage pipe (CMP) through the levee, 9.5 feet below the crown. Flap gate on the waterside (WS) end. Concrete headwall on the landside (LS) end. Concrete U-shaped headwall on the WS end. [Additional Reference(s): DWR Levee Log, 2002, (HLM 2.49). USACE San Joaquin O&M Manual, Unit No. 601, Part No. 1, 1967, Amended in 1978, Revised 20 June 1985, (HLM 2.48). DWR As-Built Specification No. 63-25, Sheet No. 12, 9 May 1963, (HLM 2.48)].

LS view: Slope and headwall at toe.

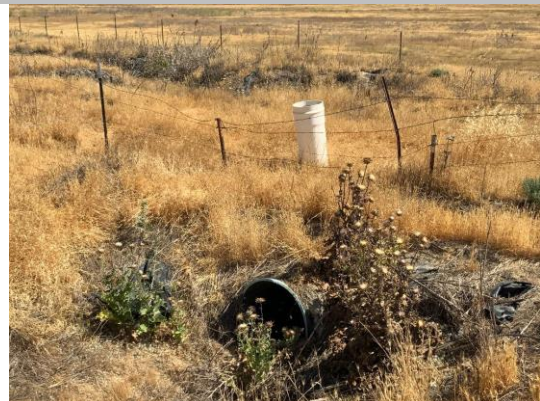
Photo 2 of 3 : UCIP_FA_2024_71173_99493.jpg

LS view: Pipe inlet and riser with flowmeter off toe.

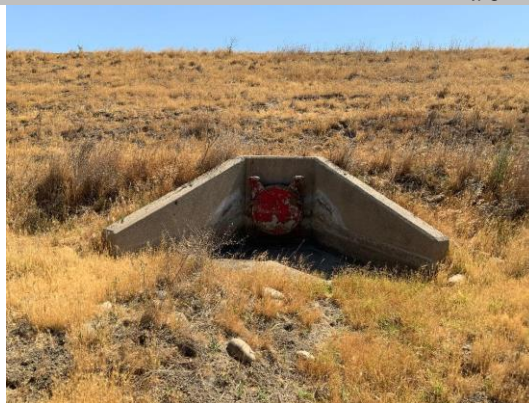
Photo 2 of 3 : UCIP_FA_2024_71174_99505.jpg

WS view: Slope, headwall, and flapgate at toe.

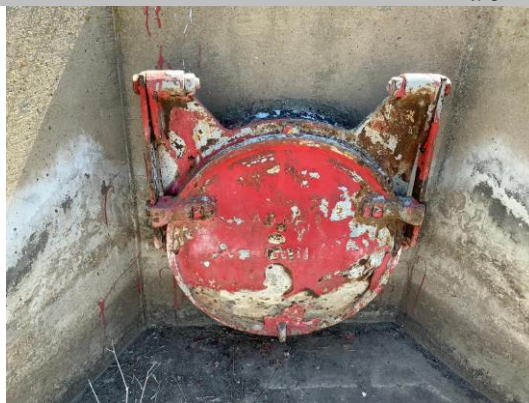
Photo 3 of 3 : UCIP_FA_2024_71174_99506.jpg

WS view: Close up of flapgate at toe.

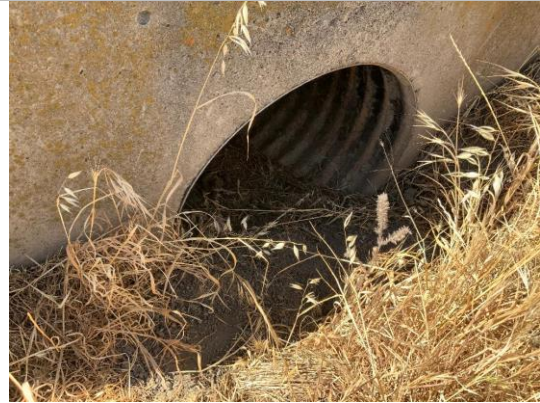
Photo 1 of 3 : UCIP_FA_2024_71175_99514.jpg

Comment Code						
Inspector Comment						
DS_ID:19901 FS_ID:71175 EP_NO: N/A Repair Type: No Action Needed EVAL Issue: Crossing Status: Found UCIP Comments: 09/18/2023 Record updated from Non-Urgent to No Action Needed. Pipe was CIPP lined. DMP internal video inspection has found none or minor pipe defects. Recommend next video inspection in 5 years. (O. Yakimov - DWR UCIP) 06/2/2021 Record remains Non-Urgent. DWR DMP internal inspection has found pipe integrity issues. LOF of crossing is equal to 4.1 and less than 5. Crossing will be monitored until funding becomes available for rehabilitation. Some sediment buildup in the inlet of the pipe on the LS, recommend cleaning out. No permit was found authorizing this encroachment. CVFPB will need to review crossing to determine owner. The UCIP inspection was completed with GEI staff, P. Espinoza. (H. Dunn ? GEI)04/15/2014 Some sediment buildup at landward toe and inside pipe--recommend clearing. (W. Wylie - DWR UCIP) FIELD_STRUCT_DESC: 24-inch CIPP-lined corrugated metal gravity drainage pipe (CMP) through the levee, 10.4 feet below the crown. Flap gate on the waterside (WS) end. Concrete headwall on the landside (LS) end. Concrete U-shaped headwall on the WS end. [Additional Reference(s): DWR Levee Log, 2002, (HLM 3.09). USACE San Joaquin O&M Manual, Unit No. 601, Part No. 1, 1967, Amended in 1978, Revised 20 June 1985, (HLM 3.09). DWR As-Built Specification No. 63-25, Sheet No. 13, 9 May 1963, (HLM 3.09)]. FS Date: 6/2/2021

LS view: Close up of pipe inlet at toe.

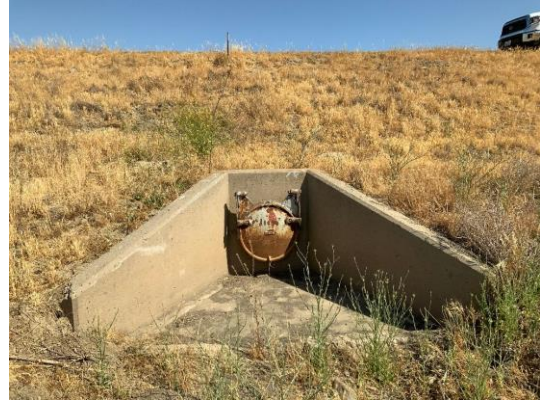
Photo 2 of 3 : UCIP_FA_2024_71175_99508.jpg

WS view: Slope, headwall, and flapgate at toe.

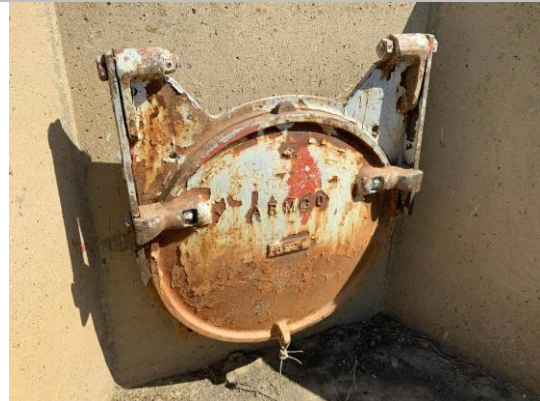
Photo 3 of 3 : UCIP_FA_2024_71175_99509.jpg

WS view: Close up of flapgate at toe.

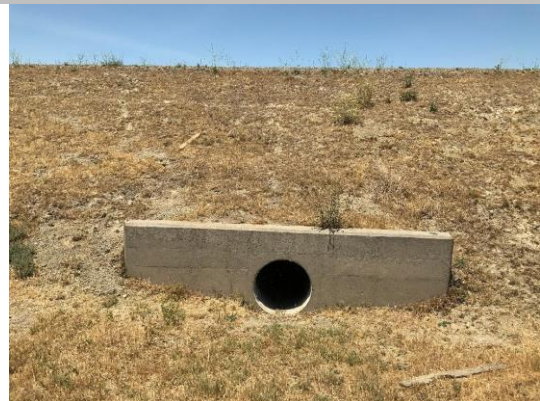
Photo 2 of 3 : UCIP_FA_2024_84919_99547.jpg

LS view: Slope and headwall at toe.

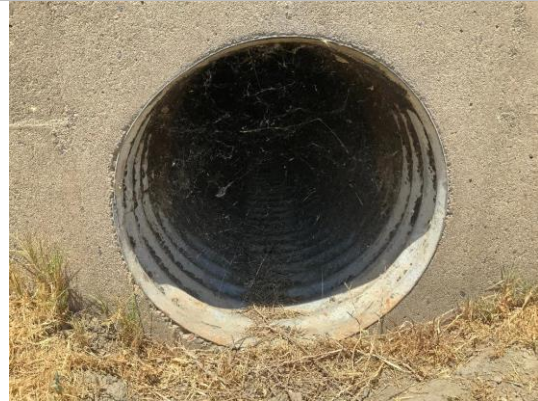
Photo 3 of 3 : UCIP_FA_2024_84919_99548.jpg

LS view: Close up of pipe inlet at toe.

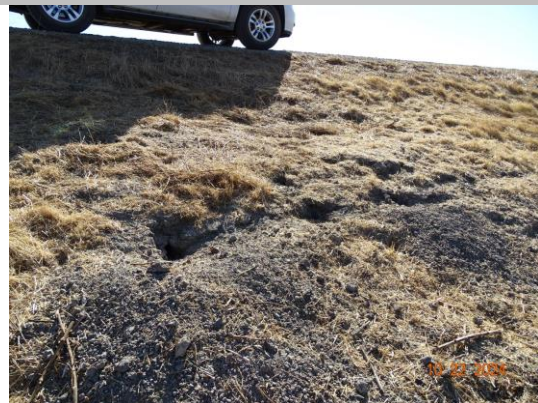
Photo 1 of 1 : FA_2024_NA0010_126_16_20241106_00038.jpg

LM Start	0.49	Rating **	M	Issue No.	16
LM End	0.49	Issue Type +	Ma	Location *	WS
Category	Earthen Levee			GPS Latitude/Longitude	
				Start	End
Item	Animal Control			37.257458 °	37.257458 °
				-120.763682 °	-120.763682 °
DWR ID	DWR_NA0010_08_f_2022_16				
Comment Code					
A1 : Exterminate rodents and backfill and compact or grout burrows.					
Inspector Comment

View of animal holes with material displaced. (Fall 2024)

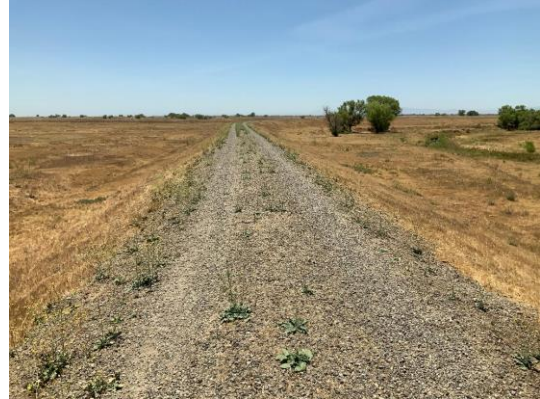
Photo 1 of 3 : UCIP_FA_2024_84920_99553.jpg

Comment Code						
Inspector Comment						
DS_ID:19904 FS_ID:84920 EP_NO: N/A Repair Type: No Action Needed EVAL Issue: Crossing Status: Found UCIP Comments: 10/04/2024 Record updated from Non-Urgent to No Action Needed. Removed code 12b since pipe is drainage and record source is Levee Log and O&M. (M. Thao - DWR UCIP) 6/2/2021 The record has been upgraded from No Action Needed to Non-Urgent. DWR DMP internal inspection has not found pipe integrity issues. LOF of crossing is less or equal to 4.0. Recommend next video inspection in 5 years. No permit was found authorizing this encroachment. CVFPB will need to review crossing to determine owner. The UCIP inspection was completed with GEI staff, P. Espinoza. (H. Dunn ? GEI) FIELD_STRUCT_DESC: 24-inch corrugated metal gravity drainage pipe (CMP) through the levee, 12.4 feet below the crown. Flap gate on the waterside (WS) end. Concrete headwall on each end. [Additional Reference(s): DWR Levee Log, 2002, (HLM 0.55). USACE San Joaquin O&M Manual, Unit No. 601, Part No. 1, 1967, Amended in 1978, Revised 20 June 1985, (HLM 0.57). DWR As-Built Specification No. 63-25, Sheet No. 11, 9 May 1963, (HLM 0.57)]. FS Date: 6/2/2021

Levee crown looking downstream.

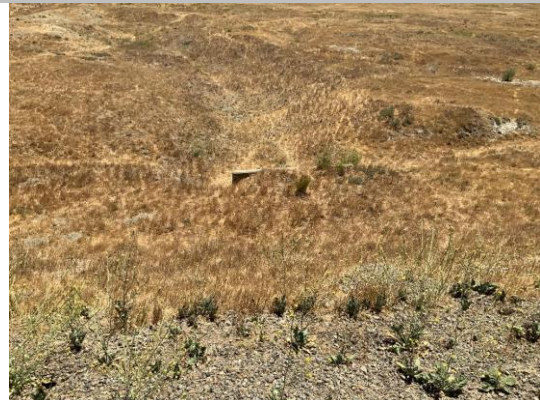
Photo 2 of 3 : UCIP_FA_2024_84920_99554.jpg

LS view: Headwall visible at toe from crown.

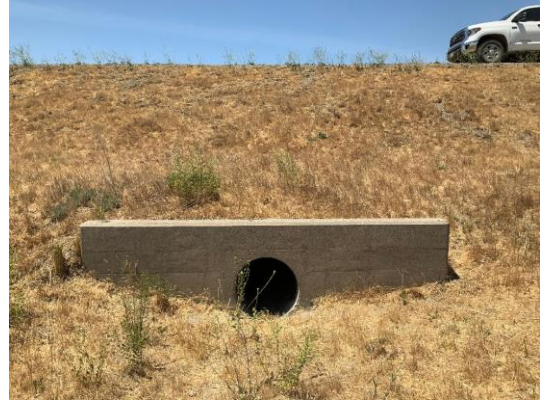
Photo 3 of 3 : UCIP_FA_2024_84920_99555.jpg

LM Start	0.57	Rating **	A	Issue No.	30 (cont)
LM End	0.57	Issue Type +	Ma	Location *	
Category	Supplemental			GPS Latitude/Longitude	
				Start	End
Item	DWR UCIP LMA Responsibility			37.258604 °	37.258604 °
				-120.763588 °	-120.763588 °
DWR ID	19904

LS view: Slope and headwall at toe.

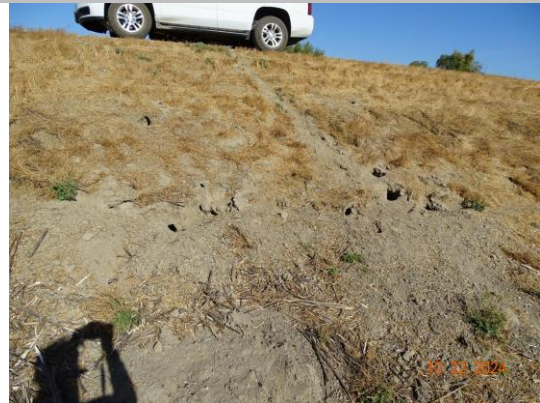
Photo 1 of 1 : FA_2024_NA0010_126_19_20241106_00039.jpg

LM Start	0.69	Rating **	M	Issue No.	19
LM End	0.69	Issue Type +	Ma	Location *	LS
Category	Earthen Levee			GPS Latitude/Longitude	
				Start	End
Item	Animal Control			37.260036 °	37.260036 °
				-120.762566 °	-120.762566 °
DWR ID	DWR_NA0010_08_f_2024_19				
Comment Code					
A3 : No rodents visible, but rodent burrows visible; need to backfill and compact or grout burrows.					
Inspector Comment

View of multiple rodent burrows on the landside slope. (Fall 2024)

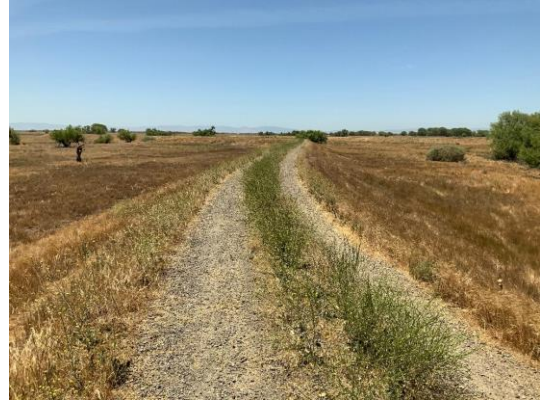
Photo 1 of 3 : UCIP_FA_2024_84921_99560.jpg

Comment Code						
Inspector Comment						
DS_ID:19905 FS_ID:84921 EP_NO: N/A Repair Type: No Action Needed EVAL Issue: Crossing Status: Found UCIP Comments: 10/04/2024 Record updated from Non-Urgent to No Action Needed. Removed code 12b since pipe is drainage and record source is Levee Log and O&M. (M. Thao - DWR UCIP) 6/2/2021 The record has been upgraded from No Action Needed to Non-Urgent. DWR DMP internal inspection has not found pipe integrity issues. LOF of crossing is less or equal to 4.0. Recommend next video inspection in 5 years. No permit was found authorizing this encroachment. CVFPB will need to review crossing to determine owner. The UCIP inspection was completed with GEI staff, P. Espinoza. (H. Dunn ? GEI) FIELD_STRUCT_DESC: 24-inch corrugated metal gravity drainage pipe (CMP) through the levee, 10.0 feet below the crown. Flap gate on the waterside (WS) end. Concrete headwall on each end. [Additional Reference(s): DWR Levee Log, 2002, (HLM 0.70). USACE San Joaquin O&M Manual, Unit No. 601, Part No. 1, 1967, Amended in 1978, Revised 20 June 1985, (HLM 0.72). DWR As-Built Specification No. 63-25, Sheet No. 11, 9 May 1963, (HLM 0.72)]. FS Date: 6/2/2021

Levee crown looking downstream.

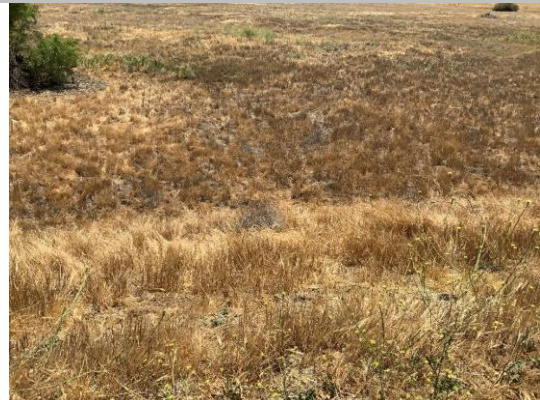
Photo 2 of 3 : UCIP_FA_2024_84921_99561.jpg

LS view: Toe from crown.

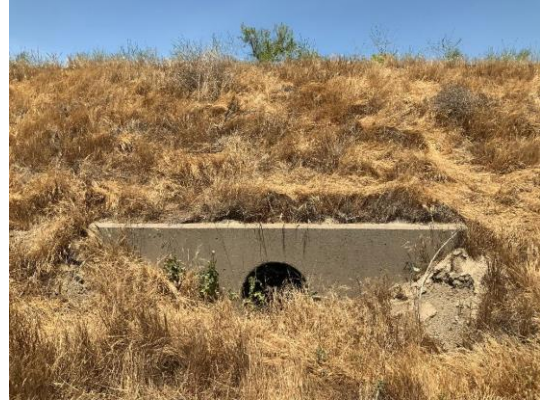
Photo 3 of 3 : UCIP_FA_2024_84921_99562.jpg

LS view: Slope and headwall at toe.

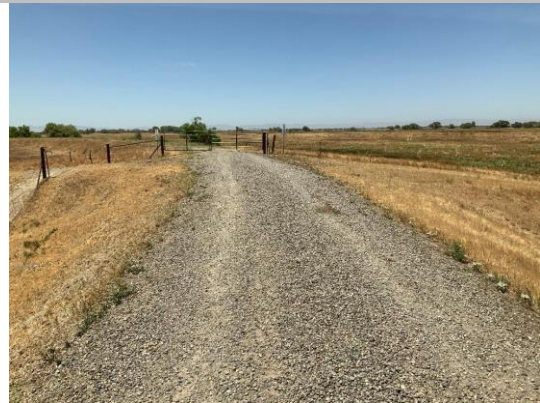
Photo 1 of 3 : UCIP_FA_2024_84922_99567.jpg

DS_ID:19832
 FS_ID:84922
 EP_NO: N/A
 Repair Type: No Action Needed
 EVAL Issue:
 Crossing Status: Found
 UCIP Comments: 10/04/2024 Record updated from Non-Urgent to No Action Needed. Removed code 12b since pipe is drainage and record source is Levee Log and O&M. (M. Thao - DWR UCIP 6/2/2021)
 Record remains Non-Urgent. DWR DMP internal inspection has not found pipe integrity issues. LOF of crossing is less or equal to 4.0. Recommend next video inspection in 5 years. No permit was found authorizing this encroachment. CVFPB will need to review crossing to determine owner. The UCIP inspection was completed with GEI staff, P. Espinoza. (H. Dunn ? GEI) 04/16/2014 Some sediment buildup at inlet on LS toe. (W. Wylie - DWR UCIP)
 FIELD_STRUCT_DESC: 24-inch corrugated metal gravity drainage pipe (CMP) through the levee, 11.5 feet below the crown. Flap gate on the waterside (WS) end. Concrete headwall on each end. [Additional Reference(s): DWR Levee Log, 2002, (HLM 0.88). USACE San Joaquin O&M Manual, Unit No. 601, Part No. 1, 1967, Amended in 1978, Revised 20 June 1985, (HLM 0.89). DWR As-Built Specification No. 63-25, Sheet No. 11, 9 May 1963, (HLM 0.89)].

Levee crown looking downstream.

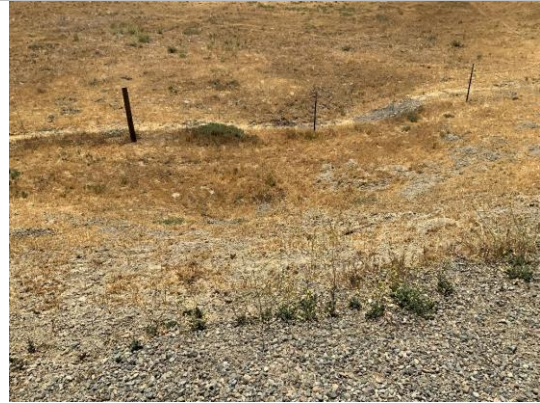
Photo 2 of 3 : UCIP_FA_2024_84922_99568.jpg

LS view: Toe from crown.

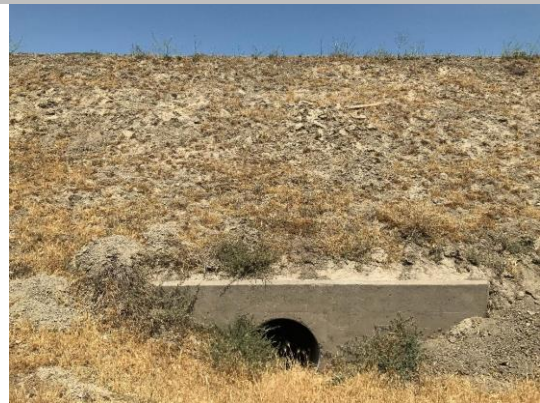
Photo 3 of 3 : UCIP_FA_2024_84922_99569.jpg

LS view: Slope and headwall at toe.

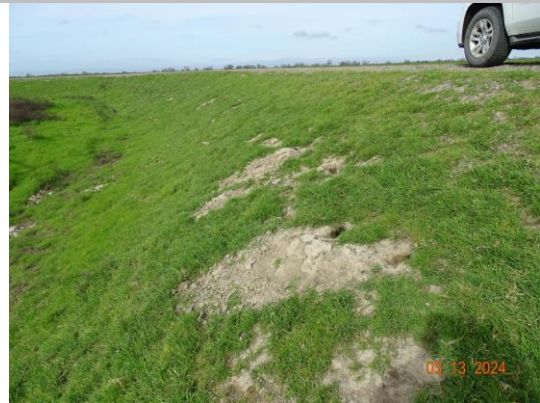
Photo 1 of 1 : FA_2024_NA0010_126_15_20240828_00001.jpg

LM Start	1.02	Rating **	M	Issue No.	15
LM End	1.02	Issue Type +	Ma	Location *	LS
Category	Earthen Levee			GPS Latitude/Longitude	
				Start	End
Item	Animal Control			37.263372 °	37.263372 °
				-120.758742 °	-120.758742 °
DWR ID	DWR_NA0010_08_s_2024_15				
Comment Code					
A3 : No rodents visible, but rodent burrows visible; need to backfill and compact or grout burrows.					
Inspector Comment

View of rodent burrows on the landside slope. (Spring 2024)

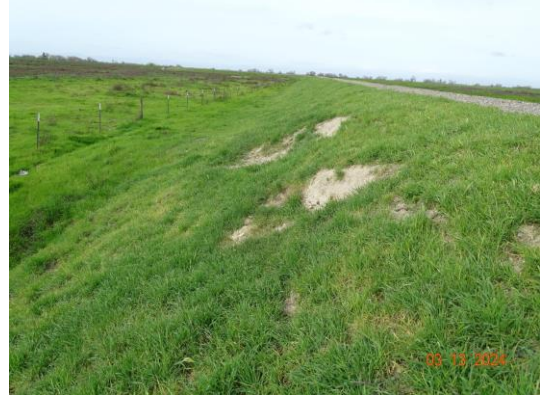
Photo 1 of 1 : FA_2024_NA0010_126_28_20240828_00007.jpg

LM Start	1.21	Rating **	M	Issue No.	28
LM End	1.21	Issue Type +	Ma	Location *	LS
Category	Earthen Levee			GPS Latitude/Longitude	
				Start	End
Item	Erosion / Livestock			37.263179 °	37.263179 °
				-120.755444 °	-120.755444 °
DWR ID	DWR_NA0010_08_f _ 2019_28				
Comment Code					
E4 : Repair the levee slope damaged by livestock and prevent large animal access.					
Inspector Comment

View of damage to the landside slope looking downstream. (Spring 2024)

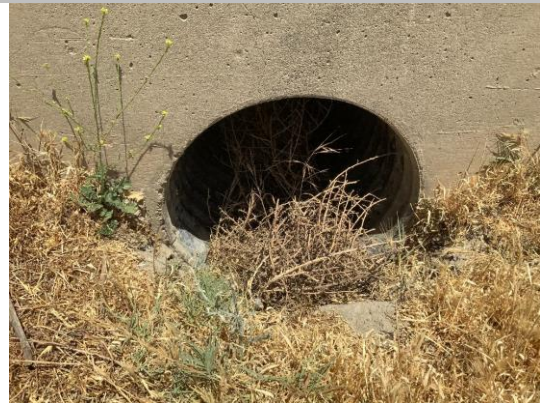
Photo 1 of 1 : UCIP_FA_2024_84972_99576.jpg

Comment Code					
Inspector Comment					
DS_ID:19833 FS_ID:84972 EP_NO: N/A Repair Type: No Action Needed EVAL Issue: Crossing Status: Found UCIP Comments: 10/08/2024 Record updated from Non-Urgent to No Action Needed. Removed code 12b since pipe is drainage and record source is Levee Log and O&M. Removed code 11 since vegetation is not maintenance of the pipe. (M. Thao - DWR UCIP) 10/6/2021 Record remains Non-Urgent. Some vegetation in LS pipe inlet, recommend clearing out. DWR DMP internal inspection has not found pipe integrity issues. LOF of crossing is less or equal to 4.0. Recommend next video inspection in 5 years. No permit was found authorizing this encroachment. CVFPB will need to review crossing to determine owner. The UCIP inspection was completed with GEI staff, P. Espinoza. (H. Dunn ? GEI) 4/16/2014 Debris blocking landward headwall-- recommend clearing. (W. Wylie - DWR UCIP) FIELD_STRUCT_DESC: 24-inch corrugated metal gravity drainage pipe (CMP) through the levee, 11.6 feet below the crown. Flap gate on the waterside (WS) end. Concrete headwall on each end. [Additional Reference(s): DWR Levee Log, 2002, (HLM 1.20). USACE San Joaquin O&M Manual, Unit No. 601, Part No. 1, 1967, Amended in 1978, Revised 20 June 1985, (HLM 1.21). DWR As-Built Specification No. 63-25, Sheet No. 11, 9 May 1963, (HLM 1.21)]. FS Date: 6/2/2021

LS view: Close up of pipe inlet at toe, some vegetation inside pipe.
