Flood Control Project Maintenance Levee Inspections

Fall 2024 Levee Maintenance Deficiency Summary Report

San Joaquin River Basin

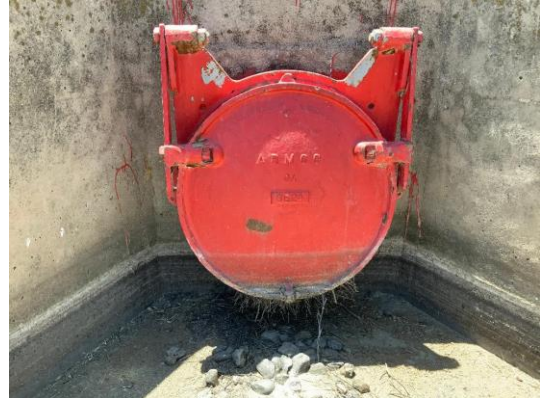
Photo 1 of 1 : UCIP_FA_2024_84973_99580.jpg

Comment Code						
Inspector Comment						
DS_ID:19834 FS_ID:84973 EP_NO: N/A Repair Type: No Action Needed EVAL Issue: Crossing Status: Found UCIP Comments: 10/08/2024 Record updated from Non-Urgent to No Action Needed. Removed code 12b since pipe is drainage and record source is Levee Log and O&M. Removed code 11 since vegetation at flap gate in minimal and does not appear to affect proper drainage of the pipe. (M. Thao - DWR UCIP 6/2/2021 Record remains Non-Urgent. Vegetation sticking out of WS flapgate, recommend removal. DWR DMP internal inspection has not found pipe integrity issues. LOF of crossing is less or equal to 4.0. Recommend next video inspection in 5 years. No permit was found authorizing this encroachment. CVFPB will need to review crossing to determine owner. The UCIP inspection was completed with GEI staff, P. Espinoza. (H. Dunn ? GEI)						
04/16/2014 Animal burrows along pipe alignment on LS. Some sediment buildup at LS toe and inside pipe--recommend clearing. (W. Wylie -DWR UCIP) FIELD_STRUCT_DESC: 24-inch corrugated metal gravity drainage pipe (CMP) through the levee, 11.5 feet below the crown. Flap gate on the waterside (WS) end. Concrete headwall on each end. [Additional Reference(s): DWR Levee Log, 2002, (HLM 1.37). USACE San Joaquin O&M Manual, Unit No. 601, Part No. 1, 1967, Amended in 1978, Revised 20 June 1985, (HLM 1.38). DWR As-Built Specification No. 63-25, Sheet No. 12, 9 May 1963, (HLM 1.38)]. FS Date: 6/2/2021

WS view: Close up of flapgate, vegetation coming out of it.

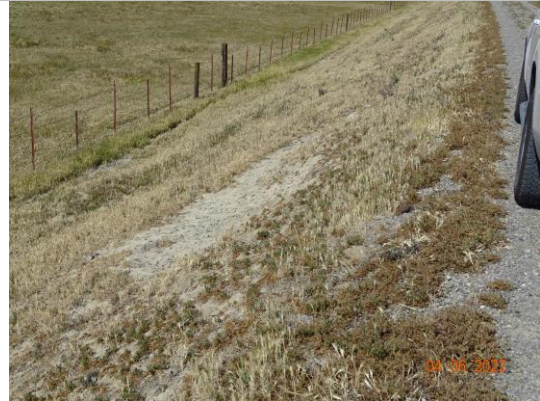
Photo 1 of 1 : FA_2024_NA0010_126_26_20240828_00006.jpg

LM Start	1.81	Rating **	M	Issue No.	26
LM End	1.81	Issue Type +	Ma	Location *	LS
Category	Earthen Levee			GPS Latitude/Longitude	
				Start	End
Item	Erosion / Livestock			37.260673 °	37.260673 °
				-120.745290 °	-120.745290 °
DWR ID	DWR_NA0010_08_f _ 2019_26				
Comment Code					
E4 : Repair the levee slope damaged by livestock and prevent large animal access.					
Inspector Comment

Looking downstream at erosion spot on the landside slope. (Spring 2022)

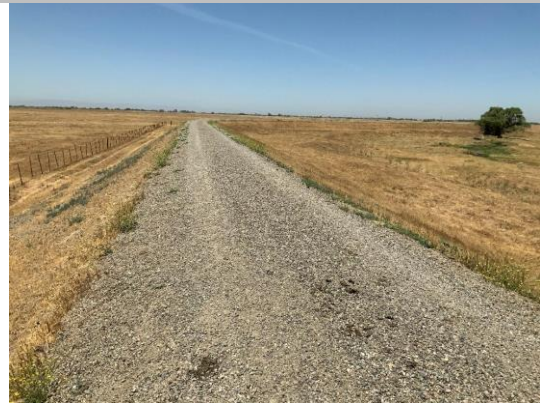
Photo 1 of 3 : UCIP_FA_2024_71183_99586.jpg

Comment Code					
Inspector Comment					
DS_ID:19835 FS_ID:71183 EP_NO: N/A Repair Type: Non-Urgent EVAL Issue: Crossing Status: Found UCIP Comments: 06/2/2021 Record remains Non-Urgent. LS pipe end not visible at all, appears to be buried or removed. Need to contact owner to determine status of pipe. DWR DMP internal inspection has not found pipe integrity issues. LOF of crossing is less or equal to 4.0. Recommend next video inspection in 5 years. No permit was found authorizing this encroachment. CVFPB will need to review crossing to determine owner. The UCIP inspection was completed with GEI staff, P. Espinoza. (H. Dunn ? GEI)04/16/2014 Non-functional landward inlet is buried in sediment. Need to contact owner to determine status. (W. Wylie - DWR UCIP) FIELD_STRUCT_DESC: 24-inch corrugated metal gravity drainage pipe (CMP) through the levee, 12.0 feet below the crown. Flap gate on the waterside (WS) end. Concrete headwall on each end. [Additional Reference(s): DWR Levee Log, 2002, (HLM 2.04). USACE San Joaquin O&M Manual, Unit No. 601, Part No. 1, 1967, Amended in 1978, Revised 20 June 1985, (HLM 2.05). DWR As-Built Specification No. 63-25, Sheet No. 12, 9 May 1963, (HLM 2.05)]. FS Date: 6/2/2021

Levee crown looking downstream.

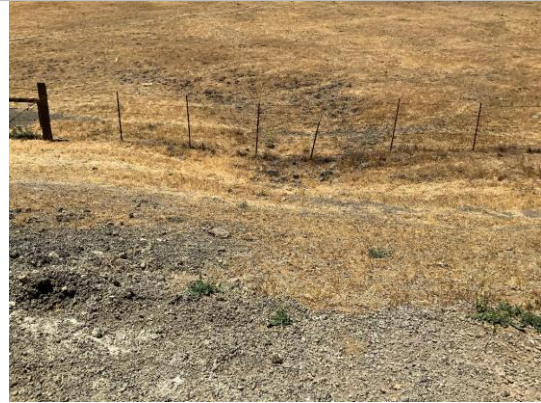
Photo 2 of 3 : UCIP_FA_2024_71183_99587.jpg

LS view: Toe from crown, no pipe visible.

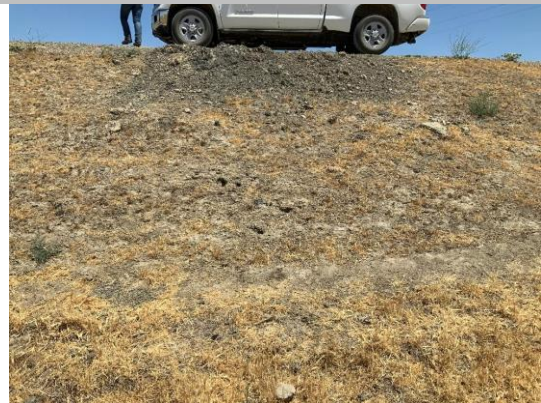
Photo 3 of 3 : UCIP_FA_2024_71183_99588.jpg

LS view: Slope from toe, no pipe visible.

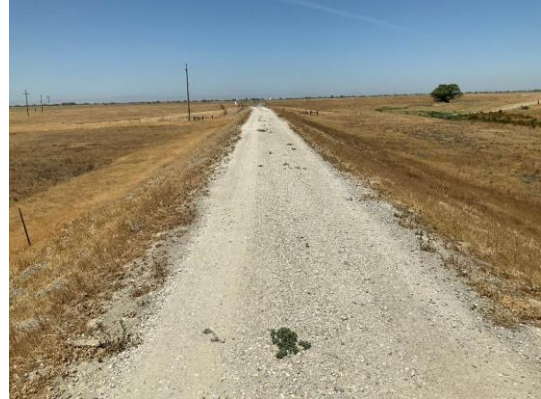
Photo 1 of 3 : UCIP_FA_2024_71184_99597.jpg

DS_ID:19836
FS_ID:71184
EP_NO: N/A
Repair Type: Non-Urgent
EVAL Issue:
Crossing Status: Found
UCIP Comments: 06/2/2021 The record remains Non-Urgent. DWR DMP internal inspection has not found pipe integrity issues. LOF of crossing is less or equal to 4.0. Recommend next video inspection in 5 years. New 6 inch plastic riser with flowmeter and 24 inch metal pipe underground off the LS toe, directly opposite of the LS pipe inlet of this DSID. No permit was found authorizing this encroachment. CVFPB will need to review crossing to determine owner. The UCIP inspection was completed with GEI staff, P. Espinoza. (H. Dunn ? GEI) 04/16/2014
Sediment buildup in pipe visible from landward side. (W. Wylie - DWR UCIP)
FIELD_STRUCT_DESC: 24-inch corrugated metal gravity drainage pipe (CMP) through the levee, 9.5 feet below the crown. Flap gate on the waterside (WS) end. Concrete headwall on each end. [Additional Reference(s): DWR Levee Log, 2002, (HLM 2.12). USACE San Joaquin O&M Manual, Unit No. 601, Part No. 1, 1967, Amended in 1978, Revised 20 June 1985, (HLM 2.12). DWR As-Built Specification No. 63-25, Sheet No. 12, 9 May 1963, (HLM 2.12)].

Levee crown looking downstream.

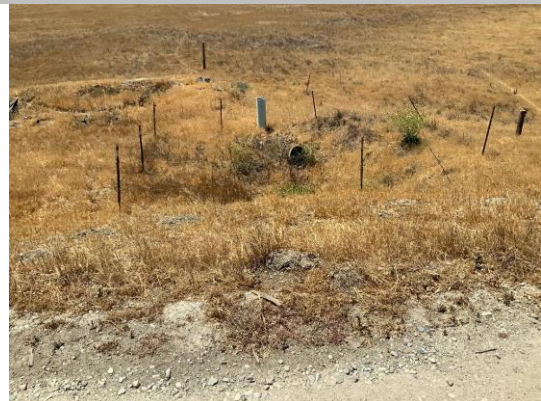
Photo 2 of 3 : UCIP_FA_2024_71184_99599.jpg

LS view: Toe from crown.

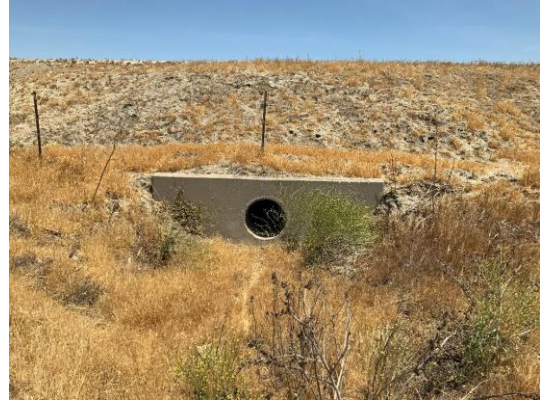
Photo 3 of 3 : UCIP_FA_2024_71184_99600.jpg

LS view: Slope and headwall at toe.

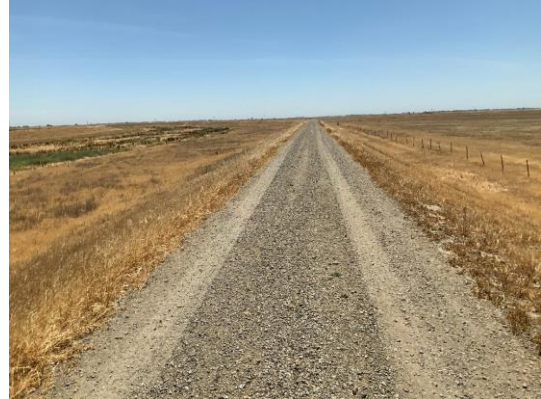
Photo 1 of 3 : UCIP_FA_2024_84925_99604.jpg

Comment Code					
Inspector Comment					
DS_ID:19837 FS_ID:84925 EP_NO: N/A Repair Type: No Action Needed EVAL Issue: Crossing Status: Found UCIP Comments: 10/04/2024 Record updated from Non-Urgent to No Action Needed. Removed code 12b since pipe is drainage and record source is Levee Log and O&M. (M. Thao - DWR UCIP 6/2/2021 The record has been upgraded from No Action Needed to Non-Urgent. DWR DMP internal inspection has not found pipe integrity issues. LOF of crossing is less or equal to 4.0. Recommend next video inspection in 5 years. No permit was found authorizing this encroachment. CVFPB will need to review crossing to determine owner. The UCIP inspection was completed with GEI staff, P. Espinoza. (H. Dunn ? GEI) FIELD_STRUCT_DESC: 24-inch corrugated metal gravity drainage pipe (CMP) through the levee, 10.5 feet below the crown. Flap gate on the waterside (WS) end. Concrete headwall on each end. [Additional Reference(s): DWR Levee Log, 2002, (HLM 2.77). USACE San Joaquin O&M Manual, Unit No. 601, Part No. 1, 1967, Amended in 1978, Revised 20 June 1985, (HLM 2.77). DWR As-Built Specification No. 63-25, Sheet No. 13, 9 May 1963, (HLM 2.77)]. FS Date: 6/2/2021

Levee crown looking downstream.

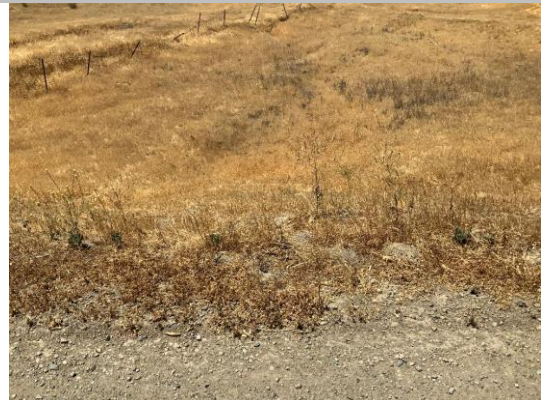
Photo 2 of 3 : UCIP_FA_2024_84925_99605.jpg

LS view: Toe from crown.

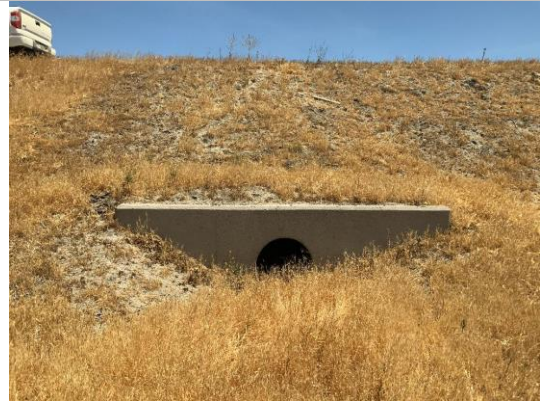
Photo 3 of 3 : UCIP_FA_2024_84925_99606.jpg

LS view: Slope and headwall at toe.

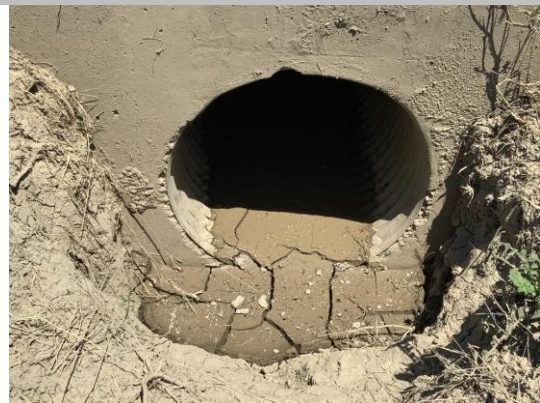
Photo 1 of 1 : UCIP_FA_2024_71186_99610.jpg

DS_ID:19838
FS_ID:71186
EP_NO: N/A
Repair Type: Non-Urgent
EVAL Issue: 11, Maintenance Compliance Issue
Crossing Status: Found
UCIP Comments: 06/2/2021 Record remains Non-Urgent. LS pipe inlet has some sediment buildup, recommend cleaning out. No permit was found authorizing this encroachment. CVFPB will need to review crossing to determine owner. The UCIP inspection was completed with GEI staff, P. Espinoza. (H. Dunn ? GEI 7/20/2016 LS inlet buried under dense vegetation. Dense vegetation limits the inspector's visibility to identify signs of pipe failure (leaks) along the WS and LS slope. Recommend removing vegetation along pipe alignment to conduct proper inspection of structure and appurtenances. (O. Magana - DWR UCIP 4/16/2014 Pipe blocked by silt on LS toe. Flapgate rusty and does not operate correctly. (W. Wylie - DWR UCIP)
FIELD_STRUCT_DESC: 36-inch corrugated metal gravity drainage pipe (CMP) through the levee, 13.4 feet below the crown. Flap gate on the waterside (WS) end. Concrete headwall on each end. [Additional Reference(s): DWR Levee Log, 2002, (HLM 3.06). USACE San Joaquin O&M Manual, Unit No. 601, Part No. 1, 1967, Amended in 1978, Revised 20 June 1985, (HLM 3.06). DWR As-Built Specification No. 63-25, Sheet No. 13, 9 May 1963, (HLM 3.06)].

LS view: Close up of pipe inlet at toe, some sediment buildup.

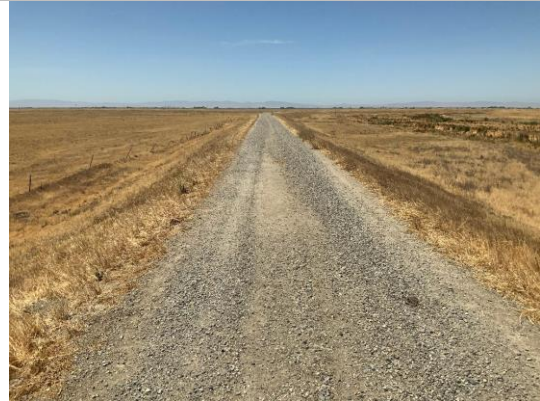
Photo 1 of 3 : UCIP_FA_2024_84926_99618.jpg

Comment Code						
Inspector Comment						
DS_ID:19839 FS_ID:84926 EP_NO: N/A Repair Type: No Action Needed EVAL Issue: Crossing Status: Found UCIP Comments: 10/04/2024 Record updated from Non-Urgent to No Action Needed. Removed code 12b since pipe is drainage and record source is Levee Log and O&M. (M. Thao - DWR UCIP 06/02/2021) The record has been upgraded from No Action Needed to Non-Urgent. DWR DMP internal inspection has not found pipe integrity issues. LOF of crossing is less or equal to 4.0. Recommend next video inspection in 5 years. No permit was found authorizing this encroachment. CVFPB will need to review crossing to determine owner. The UCIP inspection was completed with GEI staff, P. Espinoza. (H. Dunn ? GEI) FIELD_STRUCT_DESC: 24-inch corrugated metal gravity drainage pipe (CMP) through the levee, 10.0 feet below the crown. Flap gate on the waterside (WS) end. Concrete headwall on each end. [Additional Reference(s): DWR Levee Log, 2002, (HLM 3.23). USACE San Joaquin O&M Manual, Unit No. 601, Part No. 1, 1967, Amended in 1978, Revised 20 June 1985, (HLM 3.24). DWR As-Built Specification No. 63-25, Sheet No. 13, 9 May 1963, (HLM 3.24)]. FS Date: 6/2/2021

Levee crown looking downstream

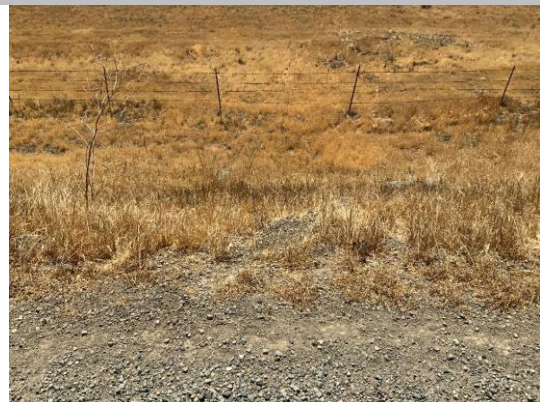
Photo 2 of 3 : UCIP_FA_2024_84926_99619.jpg

LS view: Toe from crown.

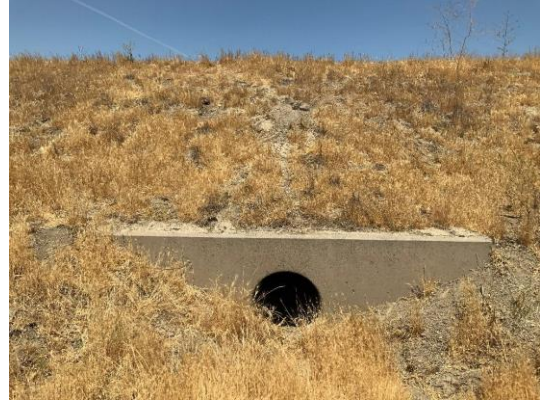
Photo 3 of 3 : UCIP_FA_2024_84926_99620.jpg

LS view: Slope and headwall at toe.

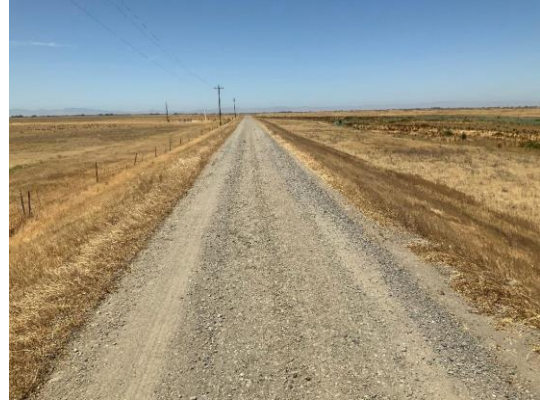
Photo 1 of 3 : UCIP_FA_2024_71188_99624.jpg

Comment Code						
Inspector Comment						
DS_ID:19840 FS_ID:71188 EP_NO: N/A Repair Type: Non-Urgent EVAL Issue: Crossing Status: Found UCIP Comments: 06/2/2021 Record remains Non-Urgent. LS pipe inlet blocked by barbed wire and both ends blocked by water, so limited inspection was done. No permit was found authorizing this encroachment. CVFPB will need to review crossing to determine owner. The UCIP inspection was completed with GEI staff, P. Espinoza. (H. Dunn ? GEI)4/16/2014 No access available on landward side. Need to confirm status of crossing. (W. Wylie - DWR UCIP) FIELD_STRUCT_DESC: 24-inch corrugated metal gravity drainage pipe (CMP) through the levee, 13.0 feet below the crown. Flap gate on the waterside (WS) end. Concrete headwall on each end. [Additional Reference(s): DWR Levee Log, 2002, (HLM 3.43). USACE San Joaquin O&M Manual, Unit No. 601, Part No. 1, 1967, Amended in 1978, Revised 20 June 1985, (HLM 3.43). DWR As-Built Specification No. 63-25, Sheet No. 13, 9 May 1963, (HLM 3.43)]. FS Date: 6/2/2021

Levee crown looking downstream.

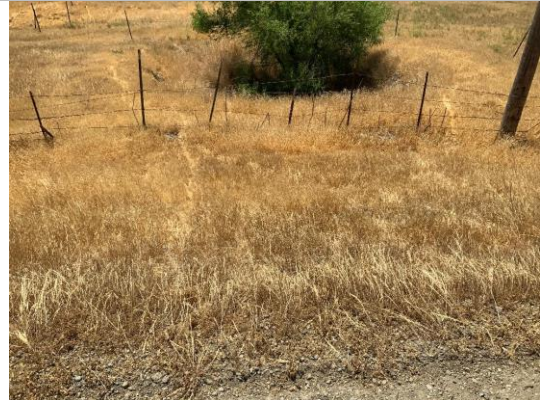
Photo 2 of 3 : UCIP_FA_2024_71188_99625.jpg

LS view: Toe from crown.

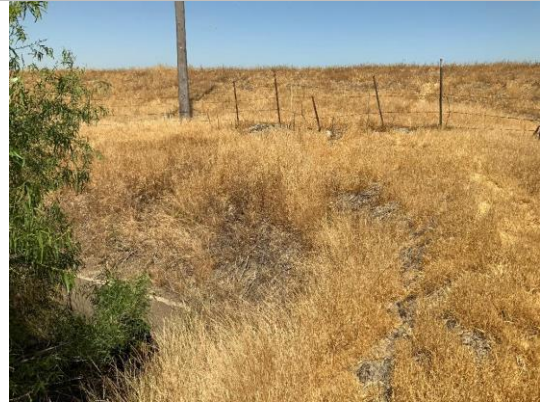
Photo 3 of 3 : UCIP_FA_2024_71188_99626.jpg

LS view: Slope from toe.

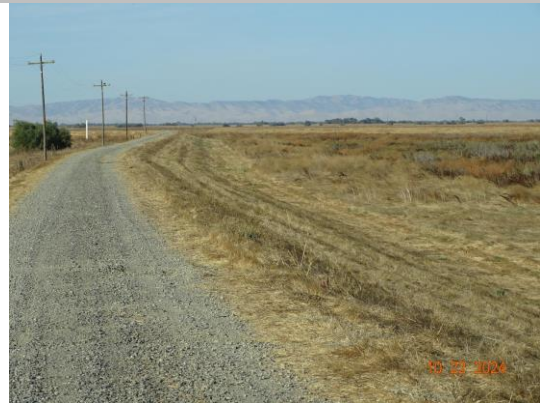
Photo 1 of 1 : FA_2024_NA0010_126_13_20241106_00040.jpg

LM Start	3.58	Rating **	A	Issue No.	13
LM End	3.58	Issue Type +	Ma	Location *	WS
Category	Earthen Levee			GPS Latitude/Longitude	
				Start	End
Item	Vegetation			37.253796°	37.253796°
				-120.719533°	-120.719533°
DWR ID	DWR_NA0010_08_f_2024_13				
Comment Code					
V1 : Control annual grass and weeds on the levee slopes and easements.					
Inspector Comment					
Annual vegetation is well maintained.

View of vegetation management on the waterside slope. (Fall 2024)

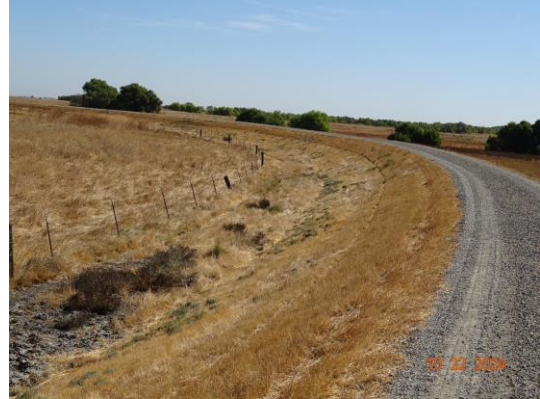
Photo 1 of 1 : FA_2024_NA0010_127_4_20241106_00009.jpg

LM Start	0.06	Rating **	A	Issue No.	4
LM End	0.06	Issue Type +	Ma	Location *	LS
Category	Earthen Levee			GPS Latitude/Longitude	
				Start	End
Item	Vegetation			37.219659 °	37.219659 °
				-120.712287 °	-120.712287 °
DWR ID	DWR_NA0010_09_f_2024_4				
Comment Code					
V1 : Control annual grass and weeds on the levee slopes and easements.					
Inspector Comment

View of vegetation management on the landside slope. (Fall 2024)

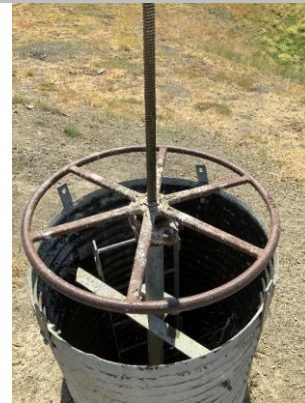
Photo 1 of 1 : UCIP_FA_2024_73203_103172.jpg

Comment Code						
Inspector Comment						
DS_ID:19841 FS_ID:73203 EP_NO: N/A Repair Type: Non-Urgent EVAL Issue: 4b, Safety Issue Crossing Status: Found UCIP Comments: 06/09/2021 The record remains Non-Urgent. Limited inspection of landside (LS) and WS due to water and mud. LS CMP riser has missing lid. WS outlet pipe edges are warped. No permit was found authorizing this encroachment. CVFPB will need to review crossing to determine owner. The UCIP inspection was completed with GEI staff, H.Dunn. (P.Espinoza ? GEI)04/22/2014 Concrete headwalls on landward and waterward under water. Need photo to confirm condition of concrete headwalls, pipe, and gate on both toes. (W. Wylie - DWR UCIP) FIELD_STRUCT_DESC: 24-inch corrugated metal gravity drainage pipe (CMP) through the levee, 18.7 feet below the crown. Slide gate in a 36-inch CMP riser unit on the waterside (WS) slope. Concrete U-shaped headwall on each end. [Additional Reference(s): DWR Levee Log, 2002, (HLM 0.48). USACE San Joaquin O&M Manual, Unit No. 601, Part No. 1, 1967, Amended in 1978, Revised 20 June 1985, (HLM 0.47). DWR As-Built Specification No. 63-25, Sheet No. 14, 9 May 1963, (HLM 0.47)]. FS Date: 6/9/2021 2:41:00 PM

WS view: Close-up of slide gate in CMP riser on slope.

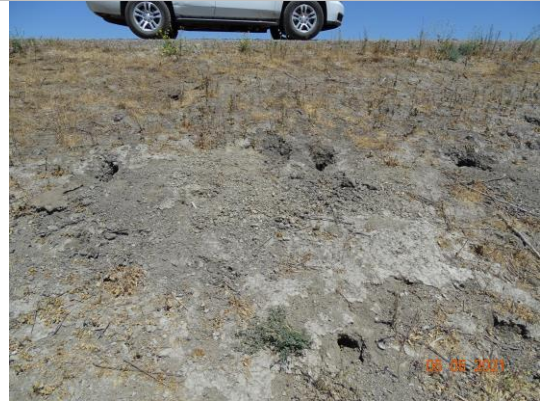
Photo 1 of 1 : FA_2024_NA0010_127_6_20240828_00002.jpg

LM Start	0.48	Rating **	M	Issue No.	6
LM End	0.48	Issue Type +	Ma	Location *	WS
Category	Earthen Levee			GPS Latitude/Longitude	
				Start	End
Item	Animal Control			37.220489°	37.220489°
				-120.705021°	-120.705021°
DWR ID	DWR_NA0010_09_s_2021_6				
Comment Code					
A1 : Exterminate rodents and backfill and compact or grout burrows.					
Inspector Comment

View of rodent burrows in the waterside slope. (Spring 2021)

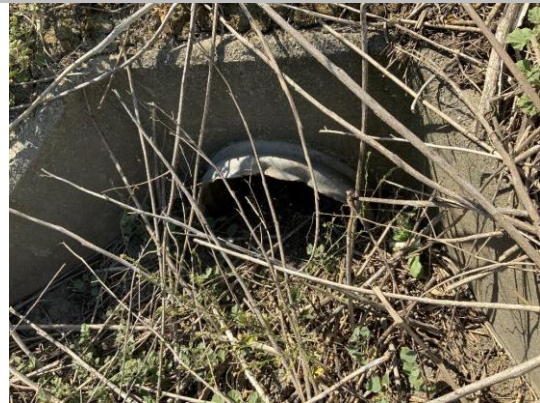
Photo 1 of 2 : UCIP_FA_2024_73200_103189.jpg

DS_ID:19843
FS_ID:73200
EP_NO: N/A
Repair Type: Non-Urgent
EVAL Issue: 4b, Safety Issue
Crossing Status: Found
UCIP Comments: 06/09/2021 The record has been upgraded from No Action Needed to Non-Urgent. No cover or handle on CMP riser on WS slope. Water in riser shows evidence that flapgate is open. Outlet pipe on WS toe not found. Dense vegetation and sediment limits inspectors ability to identify signs of inlet pipe condition on LS toe recommend removal of vegetation and sediment. LS inlet pipe appears to have slight warping around edges. No permit was found authorizing this encroachment. CVFPB will need to review crossing to determine owner. The UCIP inspection was completed with GEI staff, H.Dunn. (P.Espinoza ? GEI)
FIELD_STRUCT_DESC: [Crane Irrigation Structure] 24-inch corrugated metal gravity drainage pipe (CMP) through the levee, 9.7 feet below the crown. Two slide gates in a 48-inch CMP riser unit on the waterside (WS) slope. Concrete U-shaped headwall on the landside (LS) end. WS end cobble revetted on the bank and in the outlet drain. [Additional Reference(s): DWR Levee Log, 2002, (HLM 0.87). USACE San Joaquin O&M Manual, Unit No. 601, Part No. 1, 1967, Amended in 1978, Revised 20 June 1985, (HLM 0.87). DWR As-Built Specification No. 63-25, Sheet No. 14, 9 May 1963, (HLM 0.87)].

LS view: concrete headwall and inlet at LS toe.

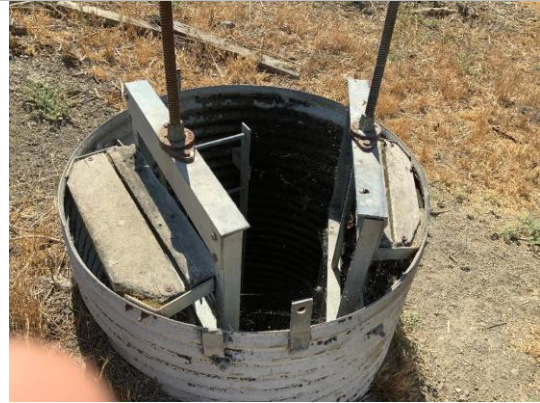
Photo 2 of 2 : UCIP_FA_2024_73200_103184.jpg

WS view: CMP riser with slide gate on slope.

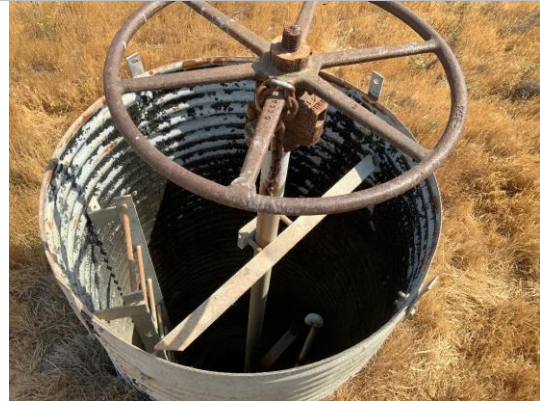
Photo 1 of 1 : UCIP_FA_2024_81002_103402.jpg

Comment Code						
Inspector Comment						
DS_ID:19845 FS_ID:81002 EP_NO: N/A Repair Type: Urgent EVAL Issue: 1, Pipe Integrity Crossing Status: Found UCIP Comments: 09/15/2023 Record updated from Non-Urgent to Urgent. DMP internal video inspection has found severe pipe defects. Crossing will be monitored until funding becomes available to address the issues. (O. Yakimov - DWR UCIP) 06/09/2021 The record remains Non-Urgent. No cover on CMP riser on WS slope, creating a safety hazard. Limited inspection of inlet pipe on LS and outlet pipe on WS due to elevated water levels around the headwalls and inlet/outlets, limiting the ability to inspect pipes at a close proximity. No permit was found authorizing this encroachment. CVFPB will need to review crossing to determine owner. The UCIP inspection was completed with GEI staff, H.Dunn. (P.Espinoza ? GEI) 04/22/2014 Inlet blocked at LS toe by wooden gate. Need to contact owner to determine status. (W. Wylie - DWR UCIP) FIELD_STRUCT_DESC: 36-inch corrugated metal gravity drainage pipe (CMP) through the levee, 19.6 feet below the crown. Slide gate in a 48-inch CMP riser unit on the waterside (WS) slope. Concrete U-shaped headwall on each end. [Additional Reference(s): DWR Levee Log, 2002, (HLM 0.31). USACE San Joaquin O&M Manual, Unit No. 601, Part No. 1, 1967, Amended in 1978, Revised 20 June 1985, (HLM 0.31). DWR As-Built Specification No. 63-25, Sheet No. 14, 9 May 1963, (HLM 0.31)]. FS Date: 6/9/2021 11:34:00 AM

WS view: Closeup of CMP riser with slidegate on slope.

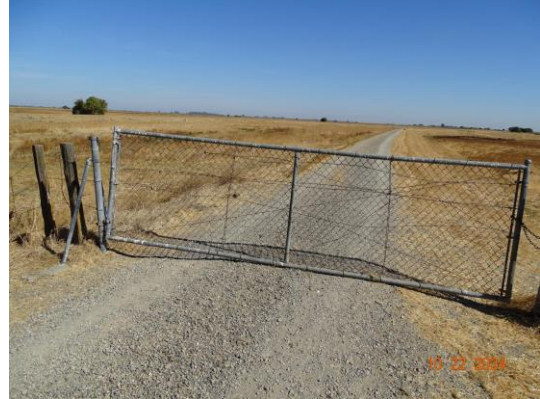
Photo 1 of 1 : FA_2024_NA0010_128_4_20241106_00003.jpg

LM Start	0.31	Rating **	M	Issue No.	4
LM End	0.31	Issue Type +	Ma	Location *	CR
Category	Earthen Levee			GPS Latitude/Longitude	
				Start	End
Item	Access Gates			37.219152 °	37.219152 °
				-120.706388 °	-120.706388 °
DWR ID	DWR_NA0010_10_f_2024_4				
Comment Code					
AG : Access Gates					
Inspector Comment					
Top hinge of the gate has broken off. Gate should be repaired or replaced.

The top hinge of the gate has broken off and should be repaired. (Fall 2024)

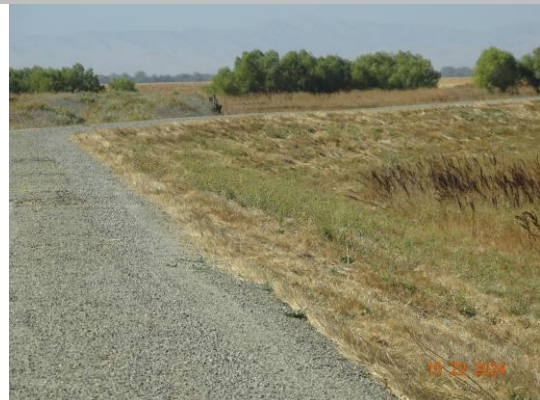
Photo 1 of 1 : FA_2024_NA0010_128_3_20241106_00004.jpg

LM Start	0.72	Rating **	A	Issue No.	3
LM End	0.72	Issue Type +	Ma	Location *	WS
Category	Earthen Levee			GPS Latitude/Longitude	
				Start	End
Item	Vegetation			37.219156 °	37.219156 °
				-120.699233 °	-120.699233 °
DWR ID	DWR_NA0010_10_f_2024_3				
Comment Code					
V1 : Control annual grass and weeds on the levee slopes and easements.					
Inspector Comment

View of vegetation management on the waterside slope. (Fall 2024)

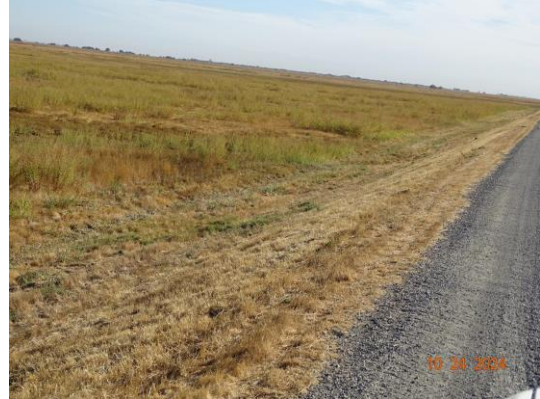
Photo 1 of 1 : FA_2024_NA0010_129_11_20241106_00023.jpg

LM Start	0.04	Rating **	A	Issue No.	11
LM End	0.04	Issue Type +	Ma	Location *	LS
Category	Earthen Levee			GPS Latitude/Longitude	
				Start	End
Item	Vegetation			37.202747 °	37.202747 °
				-120.754408 °	-120.754408 °
DWR ID	DWR_NA0010_11_f_2024_11				
Comment Code					
V1 : Control annual grass and weeds on the levee slopes and easements.					
Inspector Comment					
Annual vegetation is well maintained.

View of vegetation management on the landside slope. (Fall 2024)

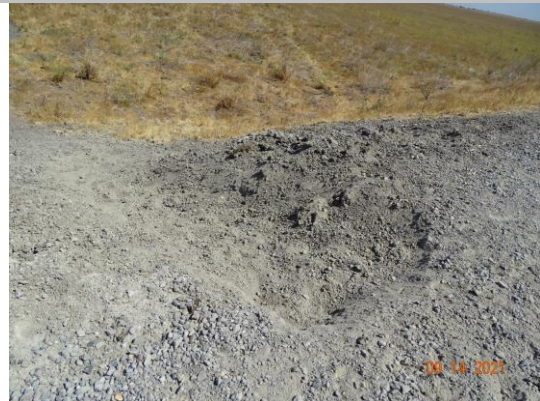
Photo 1 of 1 : FA_2024_NA0010_129_10_20240828_00002.jpg

LM Start	0.16	Rating **	A/W	Issue No.	10
LM End	0.16	Issue Type +	Ma	Location *	LS
Category	Earthen Levee			GPS Latitude/Longitude	
				Start	End
Item	Erosion / Livestock			37.202730 °	37.202730 °
				-120.752270 °	-120.752270 °
DWR ID	DWR_NA0010_11_f_2018_10				
Comment Code					
E4 : Repair the levee slope damaged by livestock and prevent large animal access.					
Inspector Comment					
Damage has been repaired. Suggest monitoring for settlement.

View of livestock damage to the landside slope. (Fall 2021)

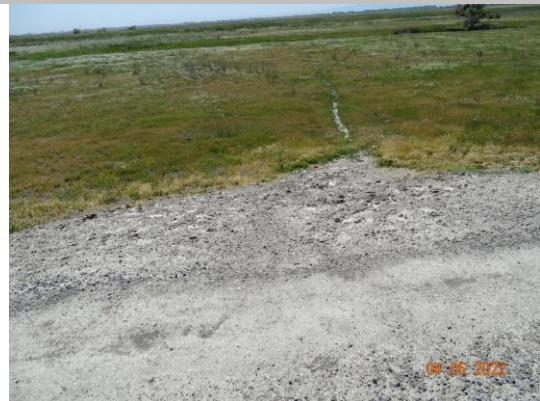
Photo 1 of 1 : FA_2024_NA0010_129_13_20240828_00003.jpg

LM Start	0.21	Rating **	A/W	Issue No.	13
LM End	0.21	Issue Type +	Ma	Location *	WS
Category	Earthen Levee			GPS Latitude/Longitude	
				Start	End
Item	Erosion / Livestock			37.202731 °	37.202731 °
				-120.751389 °	-120.751389 °
DWR ID	DWR_NA0010_11_s_2020_13				
Comment Code					
E4 : Repair the levee slope damaged by livestock and prevent large animal access.					
Inspector Comment					
Material has been placed on the levee damage. Monitor for settlement.

View of damage on waterside shoulder and slope. (Spring 2022)

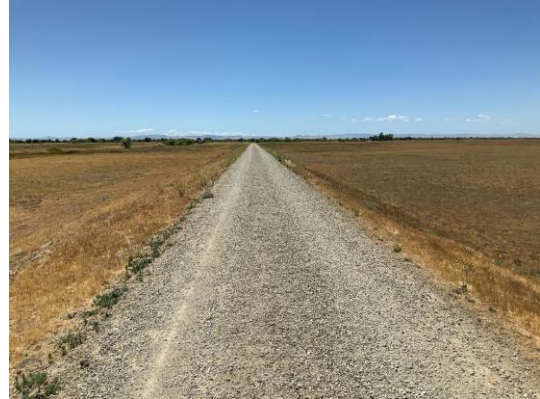
Photo 1 of 3 : UCIP_FA_2024_73267_100411.jpg

Comment Code						
Inspector Comment						
DS_ID:19846 FS_ID:73267 EP_NO: N/A Repair Type: Non-Urgent EVAL Issue: 5, Pipe Damage Crossing Status: Found UCIP Comments: 09/25/2024 DMP internal video inspection has found moderate pipe defects. Crossing will be monitored until funding becomes available for rehabilitation. (O. Yakimov - DWR UCIP) 06/8/2021 The record remains Non-Urgent. WS pipe end either completely buried under dirt or has been removed. Only riser visible on WS slope, pipe end not visible at all. Recommend contacting owner to determine status of pipe. No permit was found authorizing this encroachment. CVFPB will need to review crossing to determine owner. The UCIP inspection was completed with GEI staff, P. Espinoza. (H. Dunn- GEI)04/18/201 Need to contact owner. Recommend clearing sediment deposit inside pipe. (O. Magana - DWR UCIP) FIELD_STRUCT_DESC: 24-inch corrugated metal gravity drainage pipe (CMP) through the levee, 11.0 feet below the crown. Slide gate in a CMP riser unit on the waterside (WS) end. [Additional Reference(s): DWR Levee Log, 2002, (HLM 0.43). USACE San Joaquin O&M Manual, Unit No. 601, Part No. 1, 1967, Amended in 1978, Revised 20 June 1985, (HLM 0.42). DWR As-Built Specification No. 59-01, Sheet No. 61, 10 December 1958, (HLM 0.42)]. FS Date: 6/8/2021

Levee crown looking downstream.

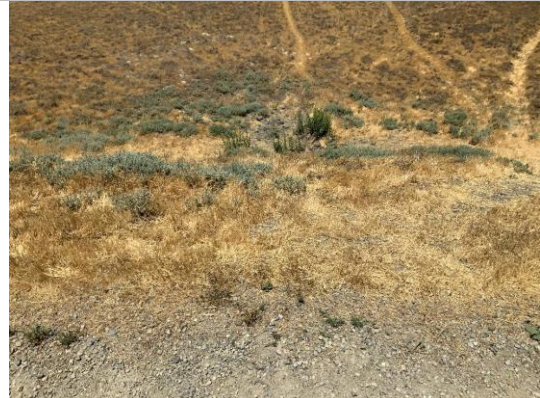
Photo 2 of 3 : UCIP_FA_2024_73267_100408.jpg

LS view: Toe from crown.

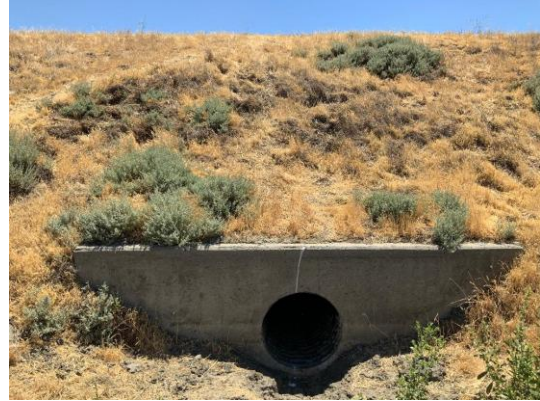
Photo 3 of 3 : UCIP_FA_2024_73267_100409.jpg

LS view: Slope and headwall at toe.

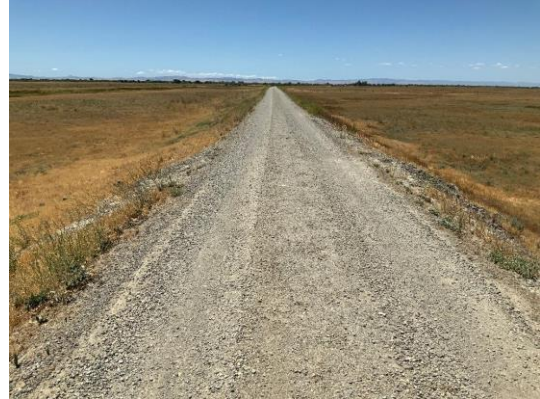
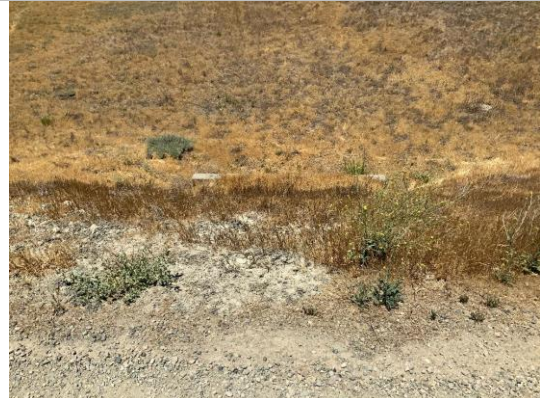
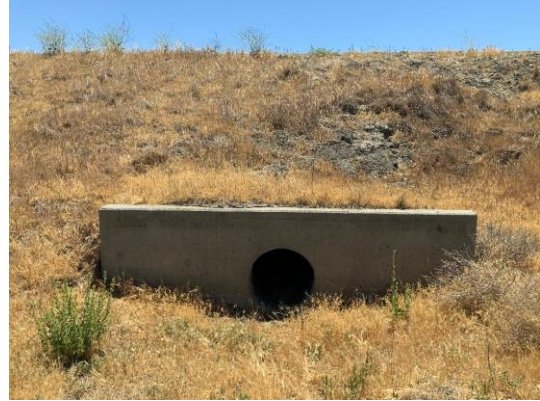
Comment Code						
Inspector Comment						
DS_ID:19848 FS_ID:84914 EP_NO: N/A Repair Type: No Action Needed EVAL Issue: Crossing Status: Found UCIP Comments: 10/04/2024 Record updated from Non-Urgent to No Action Needed. Removed code 12b since pipe is drainage and record source is Levee Log and O&M. (M. Thao - DWR UCIP) 06/8/2021 The record remains Non-Urgent. DWR DMP internal inspection has not found pipe integrity issues. LOF of crossing is less or equal to 4.0. Recommend next video inspection in 5 years. No permit was found authorizing this encroachment. CVFPB will need to review crossing to determine owner. The UCIP inspection was completed with GEI staff, P. Espinoza. (H. Dunn - GEI)04/18/201 Need to contact owner. Recommend clearing sediment deposit inside pipe. (O. Magana - DWR UCIP) FIELD_STRUCT_DESC: 24-inch corrugated metal gravity drainage pipe (CMP) through the levee, 10.3 feet below the crown. Flap gate on the waterside (WS) end. [Additional Reference(s): DWR Levee Log, 2002, (HLM 0.85). USACE San Joaquin O&M Manual, Unit No. 601, Part No. 1, 1967, Amended in 1978, Revised 20 June 1985, (HLM 0.84). DWR As-Built Specification No. 59-01, Sheet No. 61, 10 December 1958, (HLM 0.84)]. FS Date: 6/8/2021

Levee crown looking downstream.

LS view: Toe from crown.

LS view: Headwall and slope from toe.

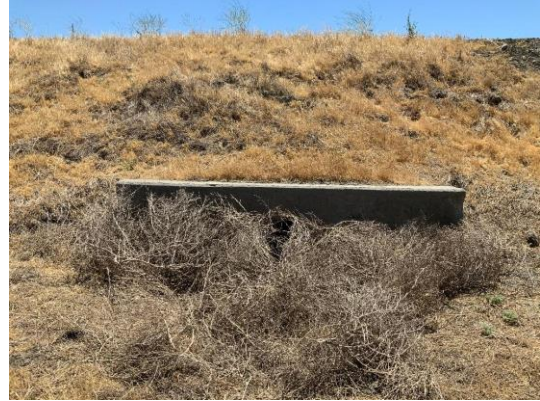
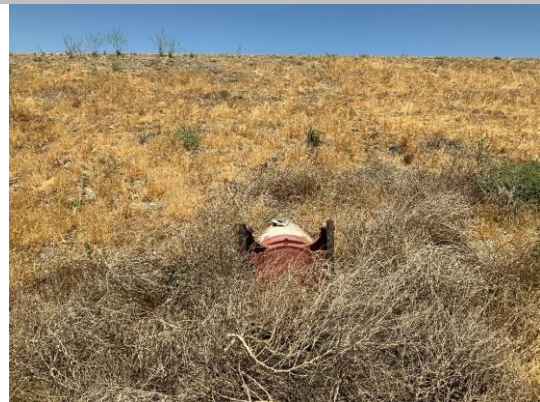
DS_ID:19849
FS_ID:84974
EP_NO: N/A
Repair Type: No Action Needed
EVAL Issue:
Crossing Status: Found
UCIP Comments: 10/08/2024 Record updated from Non-Urgent to No Action Needed. Removed code 12b since pipe is drainage and record source is Levee Log and O&M. Removed code 11 since vegetation is not maintenance of the pipe. (M. Thao - DWR UCIP 10/6/2021 The record remains Non-Urgent. DWR DMP internal inspection has not found pipe integrity issues. LOF of crossing is less or equal to 4.0. Recommend next video inspection in 5 years. Dense tumbleweeds blocking both LS and WS ends, recommend removal. No permit was found authorizing this encroachment. CVFPB will need to review crossing to determine owner. The UCIP inspection was completed with GEI staff, P. Espinoza. (H. Dunn - GEI) 04/18/2014 Need to contact owner. Recommend clearing sediment deposit inside pipe. (O. Magana - DWR UCIP)
FIELD_STRUCT_DESC: 24-inch corrugated metal gravity drainage pipe (CMP) through the levee, 9.0 feet below the crown. Flap gate on the waterside (WS) end. [Additional Reference(s): DWR Levee Log, 2002, (HLM 1.13). USACE San Joaquin O&M Manual, Unit No. 601, Part No. 1, 1967, Amended in 1978, Revised 20 June 1985, (HLM 1.13). DWR As-Built Specification No. 59-01, Sheet No. 61, 10 December 1958, (HLM 1.13)].

LS view: Headwall and slope at toe.

WS view: Flapgate and slope from toe. Dense tumbleweeds at toe.

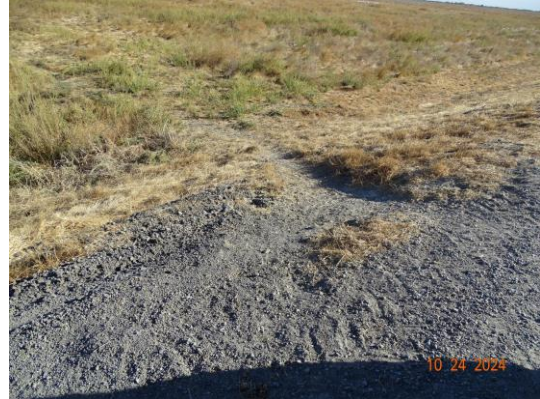
LM Start	1.49	Rating **	A/W	Issue No.	9
LM End	1.49	Issue Type +	Ma	Location *	LS
Category	Earthen Levee			GPS Latitude/Longitude	
				Start	End
Item	Erosion / Livestock			37.202748 °	37.202748 °
				-120.728182 °	-120.728182 °
DWR ID	DWR_NA0010_11_f _ 2017_9				
Comment Code					
E4 : Repair the levee slope damaged by livestock and prevent large animal access.					
Inspector Comment

View of livestock trail on the landside slope. (Fall 2024)

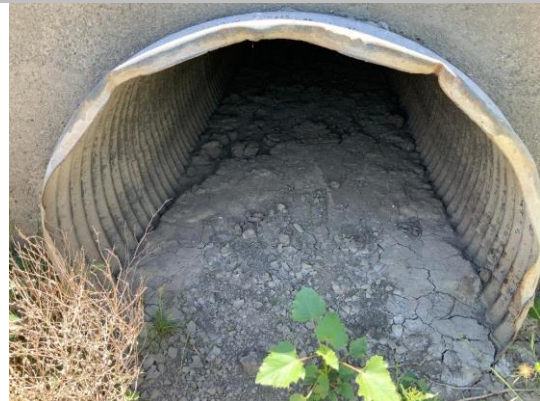
LM Start	1.49	Rating **	M	Issue No.	18
LM End	1.49	Issue Type +	Ma	Location *	
Category	Supplemental			GPS Latitude/Longitude	
				Start	End
Item	DWR UCIP LMA Responsibility			37.202753 °	37.202753 °
				-120.728133 °	-120.728133 °
DWR ID	19850				
Comment Code					
Inspector Comment

DS_ID:19850
FS_ID:73277
EP_NO: N/A
Repair Type: Non-Urgent
EVAL Issue: 11, Maintenance Compliance Issue
Crossing Status: Found
UCIP Comments: 06/8/2021 The record remains Non-Urgent. Sediment buildup in both WS and LS pipe inlet and outlet, recommend clearing out. WS pipe edges are slightly warped. No permit was found authorizing this encroachment. CVFPB will need to review crossing to determine owner. The UCIP inspection was completed with GEI staff, P. Espinoza. (H. Dunn - GEI)
04/18/2014 Need to contact owner. Recommend clearing sediment deposit inside pipe. (O. Magana - DWR UCIP)
FIELD_STRUCT_DESC: 48-inch corrugated metal gravity drainage pipe (CMP) through the levee, 16.3 feet below the crown. Slide gate in a pipe riser unit on the waterside (WS) slope. [Additional Reference(s): DWR Levee Log, 2002, (HLM 1.50). USACE San Joaquin O&M Manual, Unit No. 601, Part No. 1, 1967, Amended in 1978, Revised 20 June 1985, (HLM 1.50). DWR As-Built Specification No. 59-01, Sheet No. 62, 10 December 1958, (HLM 1.50)].

LS view: Close up of pipe inlet with sediment buildup and warped edges at toe.

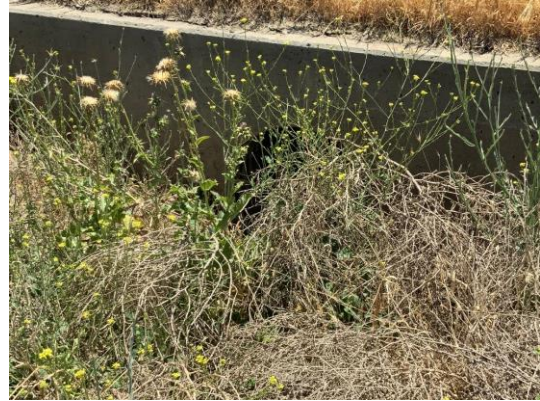
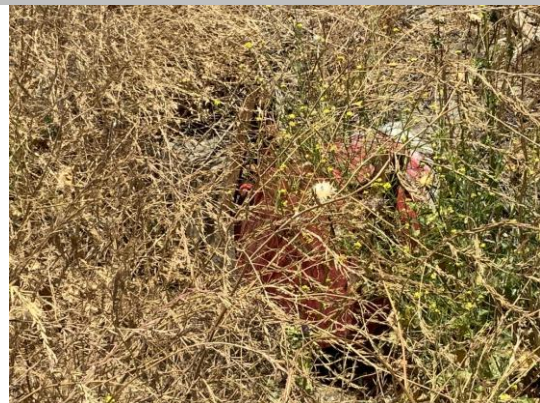
Comment Code						
Inspector Comment						
DS_ID:19851 FS_ID:73272 EP_NO: N/A Repair Type: Non-Urgent EVAL Issue: Crossing Status: Found UCIP Comments: 09/18/2023 Pipe was CIPP lined. DMP internal video inspection has found none or minor pipe defects. Recommend next video inspection in 5 years. (O. Yakimov - DWR UCIP) 06/8/2021 The record remains Non-Urgent. DWR DMP internal inspection has found pipe integrity issues. LOF of crossing is between 4.1 and 5. Crossing will be monitored until funding becomes available for rehabilitation. Vegetation on both WS and LS ends, recommend removal. No permit was found authorizing this encroachment. CVFPB will need to review crossing to determine owner. The UCIP inspection was completed with GEI staff, P. Espinoza. (H. Dunn - GEI) 04/18/2014 Need to contact owner. Recommend clearing sediment deposit inside pipe. (O. Magana - DWR UCIP) FIELD_STRUCT_DESC: 24-inch CIPP-lined corrugated metal gravity drainage pipe (CMP) through the levee, 12.8 feet below the crown. Flap gate on the waterside (WS) end. [Additional Reference(s): DWR Levee Log, 2002, (HLM 1.99). USACE San Joaquin O&M Manual, Unit No. 601, Part No. 1, 1967, Amended in 1978, Revised 20 June 1985, (HLM 1.99). DWR As-Built Specification No. 59-01, Sheet No. 62, 10 December 1958, (HLM 1.99)]. FS Date: 6/8/2021

LS view: Close up of pipe inlet at toe, covered by vegetation.

WS view: Close up of flapgate at toe, covered by vegetation.

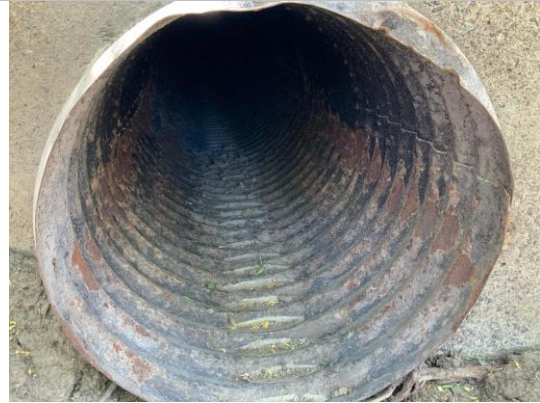
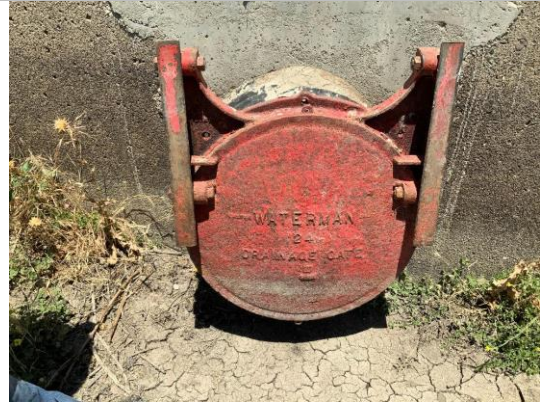
Comment Code					
Inspector Comment					
DS_ID:19852 FS_ID:84917 EP_NO: N/A Repair Type: No Action Needed EVAL Issue: Crossing Status: Found UCIP Comments: 10/04/2024 Record updated from Non-Urgent to No Action Needed. Removed code 12b since pipe is drainage and record source is Levee Log and O&M. (M. Thao - DWR UCIP) 12/20/2022 Record updated from Urgent to Non-Urgent. Pipe has been CIPP lined. LOF of crossing is less or equal to 4. Recommend next video inspection in 5 years. (O.Yakimov - DWR UCIP) 06/8/2021 The record has been upgraded from Non-Urgent to Urgent. DWR DMP internal inspection has found pipe integrity issues. LOF of crossing is between 5 and 6. Crossing will be monitored until funding becomes available to address the issues. No permit was found authorizing this encroachment. CVFPB will need to review crossing to determine owner. Pipe has since been cleared out of sediment since previous inspection. The UCIP inspection was completed with GEI staff, P. Espinoza. (H. Dunn- GEI) 4/18/201 Need to contact owner. Recommend clearing sediment deposit inside pipe. (O. Magana - DWR UCIP) FIELD_STRUCT_DESC: 24-inch CIPP-lined corrugated metal gravity drainage pipe (CMP) through the levee, 15.0 feet below the crown. Flap gate on the waterside (WS) end. [Additional Reference(s): DWR Levee Log, 2002, (HLM 3.04). USACE San Joaquin O&M Manual, Unit No. 601, Part No. 1, 1967, Amended in 1978, Revised 20 June 1985, (HLM 3.04). DWR As-Built Specification No. 59-01, Sheet No. 63, 10 December 1958, (HLM 3.04)]. FS Date: 6/8/2021 11:31:05 AM

LS view: Close up of pipe inlet at toe.

WS view: Close up of flapgate at toe.

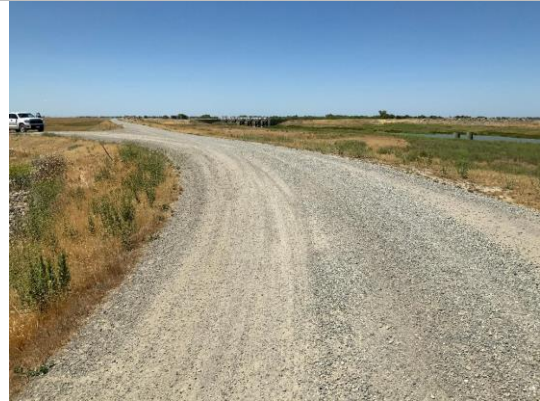
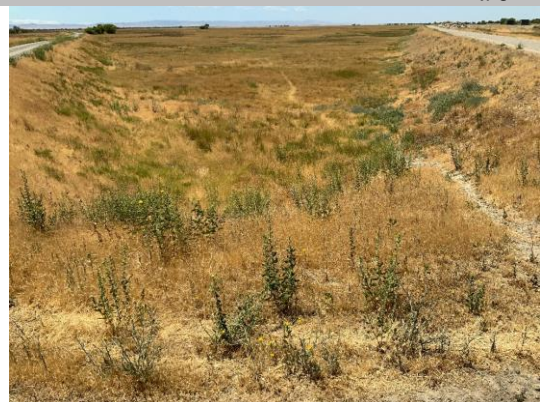
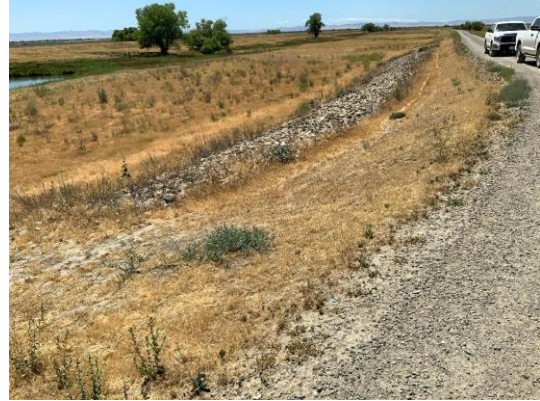
DS_ID:25542
FS_ID:79244
EP_NO: N/A
Repair Type: Non-Urgent
EVAL Issue:
Crossing Status: Not Found
UCIP Comments: 03/13/2023 Updated coordinates of the crossing to match HLM of Unit 11. Needs field verification. (O.Yakimov - DWR UCIP)
06/8/2021 The record is Non-Urgent. Pipe not found by visual inspection. This appears to potentially be inside a different unit based on the CLM since this unit only goes from CLM 0 to 3.31. Either way, it was not observed in the field. Recommend contacting owner to determine status of pipe. No permit was found authorizing this encroachment. CVFPB will need to review crossing to determine owner. The UCIP inspection was completed with GEI staff, P. Espinoza. (H. Dunn- GEI)
09/23/2020 UCIP record brought online. Confirm location. (O. Magana - DWR UCIP)
FIELD_STRUCT_DESC: 24-inch corrugated metal gravity drainage pipe (CMP) through the levee, 15.0 feet below the crown. Flap gate on the waterside (WS) end. [Additional Reference(s): DWR Levee Log, 2002, (HLM 3.32). USACE San Joaquin O&M Manual, Unit No. 601, Part No. 1, 1967, Amended in 1978, Revised 20 June 1985, (HLM 3.32). DWR As-Built Specification No. 59-01, Sheet No. 63, 10 December 1958, (HLM 3.32)].

Levee crown on adjacent unit bisecting this one.

LS view: Slope from toe, no pipe visible.

WS view: Slope from toe, no pipe visible.

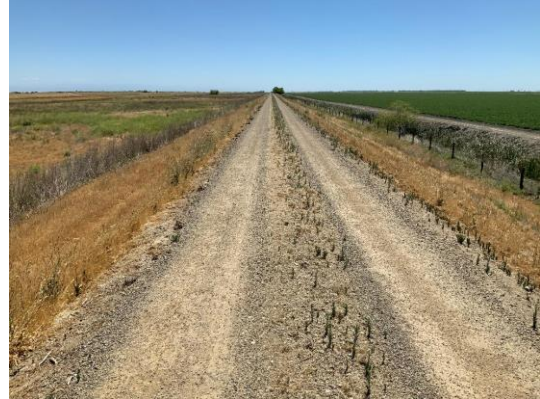
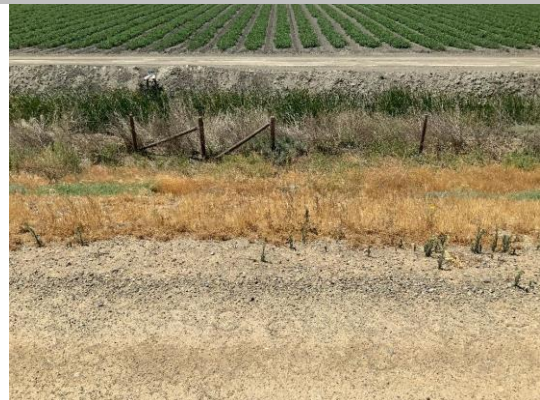
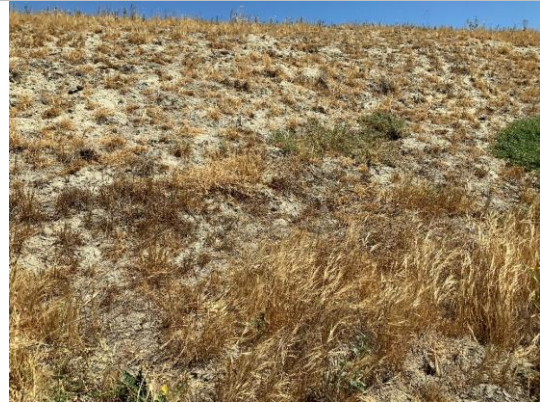
DS_ID:19855
FS_ID:84911
EP_NO: N/A
Repair Type: No Action Needed
EVAL Issue:
Crossing Status: Found
UCIP Comments: 10/04/2024 Record updated from Non-Urgent to No Action Needed. Removed code 12b since pipe is drainage and record source is Levee Log and O&M. (M. Thao - DWR UCIP)
06/08/2021 The record remains Non-Urgent. DWR DMP internal inspection has not found pipe integrity issues. LOF of crossing is less or equal to 4.0. Recommend next video inspection in 5 years. No permit was found authorizing this encroachment. CVFPB will need to review crossing to determine owner. The UCIP inspection was completed with GEI staff, P. Espinoza. (H. Dunn ? GEI)04/18/2014 Need to contact owner. Dense vegetation limits the inspector's visibility to identify signs of pipe failure (leaks) along the waterward slope. Recommend removing vegetation along pipe alignment to conduct proper inspection of structure. (O. Magana - DWR UCIP)

Levee crown looking downstream.

LS view: Toe from crown.

LS view: Slope from toe.

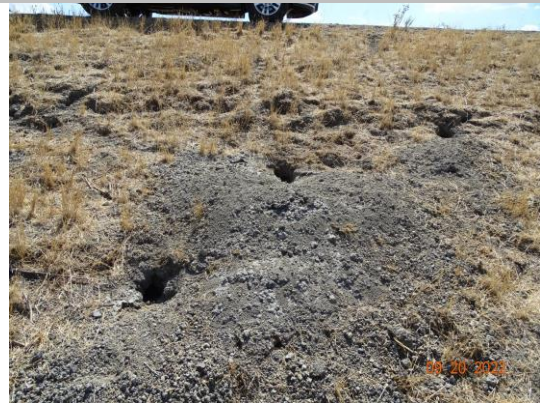
LM Start	1.05	Rating **	M	Issue No.	12
LM End	1.05	Issue Type +	Ma	Location *	WS
Category	Earthen Levee			GPS Latitude/Longitude	
				Start	End
Item	Animal Control			37.200910 °	37.200910 °
				-120.736271 °	-120.736271 °
DWR ID	DWR_NA0010_12_f_2022_12				
Comment Code					
A3 : No rodents visible, but rodent burrows visible; need to backfill and compact or grout burrows.					
Inspector Comment

View of rodent burrows on the waterside slope. (Fall 2022)

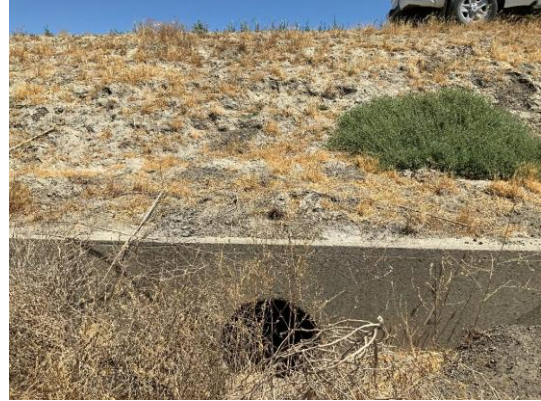
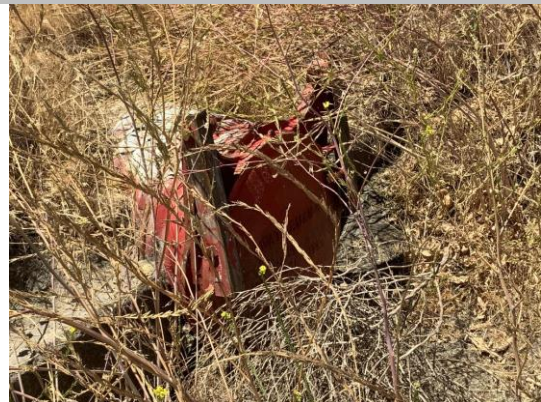
DS_ID:19856
FS_ID:84975
EP_NO: N/A
Repair Type: No Action Needed
EVAL Issue:
Crossing Status: Found
UCIP Comments: 10/07/2024 Record updated from Non-Urgent to No Action Needed. Removed code 12b since pipe is drainage and record source is Levee Log and O&M. Removed code 11 since vegetation is not maintenance of the pipe. (M. Thao - DWR UCIP 10/6/2021 The record remains Non-Urgent. DWR DMP internal inspection has not found pipe integrity issues. LOF of crossing is less or equal to 4.0. Recommend next video inspection in 5 years. Some vegetation growth starting over WS flapgate and LS pipe inlet, recommend removal. No permit was found authorizing this encroachment. CVFPB will need to review crossing to determine owner. The UCIP inspection was completed with GEI staff, P. Espinoza. (H. Dunn ? GEI) 04/18/2014 Need to contact owner. Recommend clearing sediment deposit inside pipe. (O. Magana - DWR UCIP)

LS view: Slope and headwall at toe.

WS view: Close up of flapgate at toe.

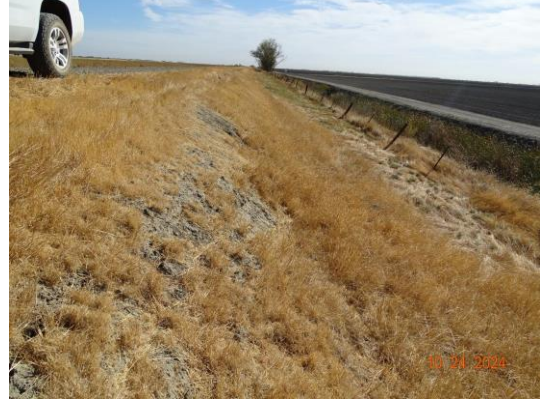
LM Start	1.06	Rating **	A/W	Issue No.	14
LM End	1.07	Issue Type +	Ma	Location *	LS
Category	Earthen Levee			GPS Latitude/Longitude	
				Start	End
Item	Erosion / Livestock			37.200924 °	37.200923 °
				-120.735998 °	-120.735747 °
DWR ID	DWR_NA0010_12_f_2023_14				
Comment Code					
E4 : Repair the levee slope damaged by livestock and prevent large animal access.					
Inspector Comment					
Damage along slope is caused by livestock cutting into the 2:1 slope. Continue to monitor.

View of damage to the landside slope. (Fall 2024)

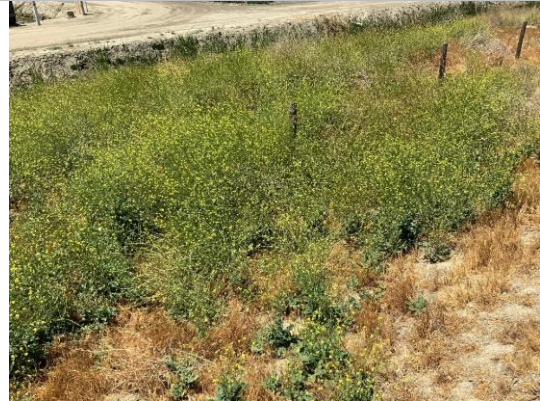
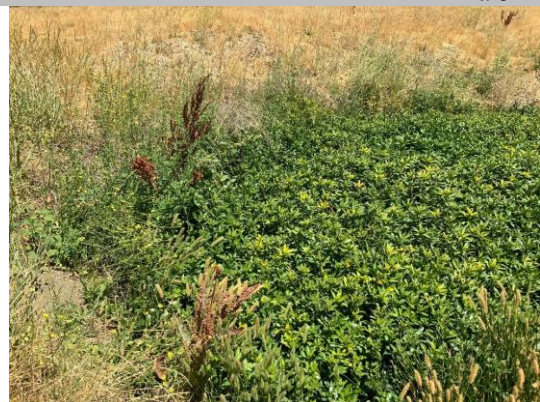
DS_ID:19857
FS_ID:73306
EP_NO: N/A
Repair Type: Non-Urgent
EVAL Issue: 11, Maintenance Compliance Issue
Crossing Status: Not Found
UCIP Comments: 06/8/2021 The record remains Non-Urgent. Pipe not found during visual inspection due to dense vegetation on both WS and LS ends. LS end was also blocked off by barbed wire which limited inspection. Recommend removing vegetation in order to assess condition of pipe. No permit was found authorizing this encroachment. CVFPB will need to review crossing to determine owner. The UCIP inspection was completed with GEI staff, P. Espinoza. (H. Dunn ? GEI)

04/18/2014 Landward side not accessible due to dense vegetation and fence. Concrete headwall and flap gate under water therefore not able to evaluate condition. Will need to coordinate with owner to evaluate condition of crossing on waterward side and obtain access to evaluate landward side. (O. Magana - DWR UCIP)
FIELD_STRUCT_DESC: 24-inch corrugated metal gravity drainage pipe (CMP) through the levee, 17.4 feet below the crown. Flap gate on the waterside (WS) end. [Additional Reference(s): DWR Levee Log, 2002, (HLM 1.28). USACE San Joaquin O&M Manual, Unit No. 601, Part No. 1, 1967, Amended in 1978, Revised 20 June 1985, (HLM 1.27). DWR As-Built Specification No. 59-01, Sheet No. 61, 10 December 1958, (HLM 1.27)].
FS Date: 6/8/2021

LS view: Dense vegetation and barbed wire at the toe, no pipe visible.

WS view: Dense vegetation covering the water at the toe, no pipe visible.

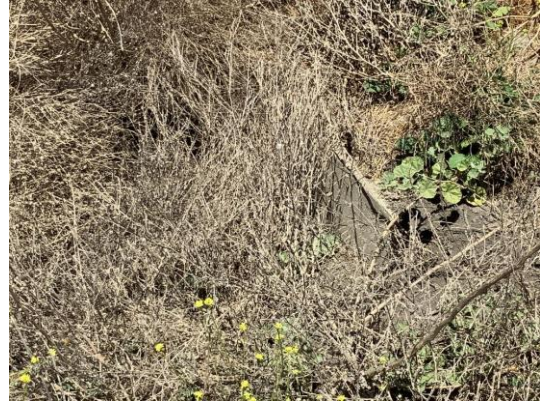
Comment Code						
Inspector Comment						
DS_ID:19858 FS_ID:73307 EP_NO: N/A Repair Type: Non-Urgent EVAL Issue: 11, Maintenance Compliance Issue Crossing Status: Found UCIP Comments: 06/8/2021 The record remains Non-Urgent. DWR DMP internal inspection has not found pipe integrity issues. LOF of crossing is less or equal to 4.0. Recommend next video inspection in 5 years. Dense vegetation over LS pipe inlet, headwall barely visible. Recommend removal of vegetation. No permit was found authorizing this encroachment. CVFPB will need to review crossing to determine owner. The UCIP inspection was completed with GEI staff, P. Espinoza. (H. Dunn ? GEI)04/18/2014 Limited access on landward side due to fence and dense vegetation. Recommend obtaining access to landward side and clear vegetation on landward side. (O. Magana - DWR UCIP) FIELD_STRUCT_DESC: 24-inch corrugated metal gravity drainage pipe (CMP) through the levee, 10.7 feet below the crown. Flap gate on the waterside (WS) end. [Additional Reference(s): DWR Levee Log, 2002, (HLM 1.53). USACE San Joaquin O&M Manual, Unit No. 601, Part No. 1, 1967, Amended in 1978, Revised 20 June 1985, (HLM 1.53). DWR As-Built Specification No. 59-01, Sheet No. 62, 10 December 1958, (HLM 1.53)]. FS Date: 6/8/2021

LS view: Headwall barely visible at toe due to dense vegetation.
