Flood Control Project Maintenance Levee Inspections

Fall 2024 Levee Maintenance Deficiency Summary Report

San Joaquin River Basin

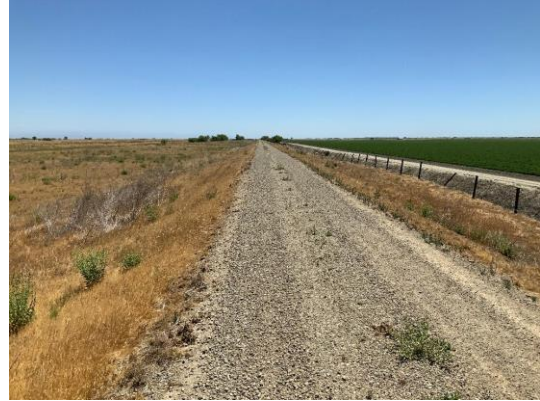
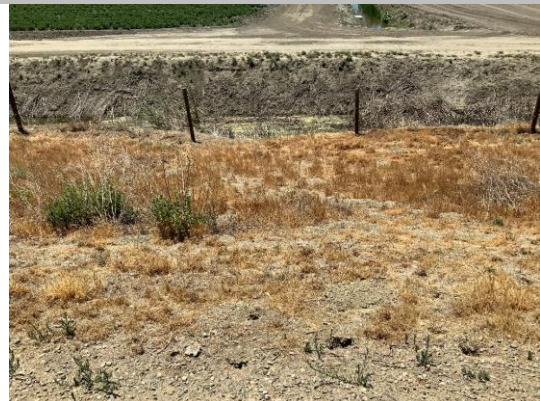
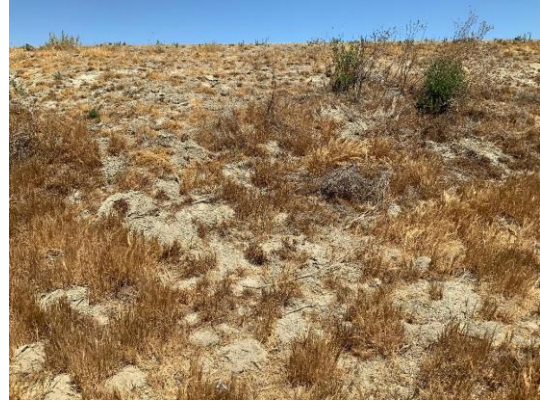
DS_ID:19859
FS_ID:73308
EP_NO: N/A
Repair Type: Non-Urgent
EVAL Issue:
Crossing Status: Found
UCIP Comments: 06/8/2021 The record remains Non-Urgent. DWR DMP internal inspection has not found pipe integrity issues. LOF of crossing is less or equal to 4.0. Recommend next video inspection in 5 years. LS pipe inlet inaccessible due to barbed wire, just the top of the headwall visible. No permit was found authorizing this encroachment. CVFPB will need to review crossing to determine owner. The UCIP inspection was completed with GEI staff, P. Espinoza. (H. Dunn ? GEI)

04/18/2014 Need to contact owner. Recommend clearing vegetation from landward side--headwall blocked. (O. Magana - DWR UCIP)
FIELD_STRUCT_DESC: 24-inch corrugated metal gravity drainage pipe (CMP) through the levee, 14.4 feet below the crown. Flap gate on the waterside (WS) end. [Additional Reference(s): DWR Levee Log, 2002, (HLM 2.16). USACE San Joaquin O&M Manual, Unit No. 601, Part No. 1, 1967, Amended in 1978, Revised 20 June 1985, (HLM 2.16). DWR As-Built Specification No. 59-01, Sheet No. 62, 10 December 1958, (HLM 2.16)].
FS Date: 6/8/2021

Levee crown looking upstream.

LS view: Toe from crown.

LS view: Slope from toe.

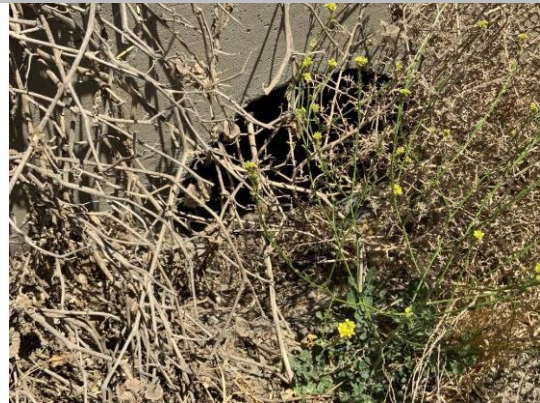
LM Start	2.70	Rating **	M	Issue No.	20
LM End	2.70	Issue Type +	Ma	Location *	
Category	Supplemental			GPS Latitude/Longitude	
				Start	End
Item	DWR UCIP LMA Responsibility			37.200906 °	37.200906 °
				-120.706316 °	-120.706316 °
DWR ID	19860

DS_ID:19860
 FS_ID:73309
 EP_NO: N/A
 Repair Type: Non-Urgent
 EVAL Issue: 11, Maintenance Compliance Issue
 Crossing Status: Found
 UCIP Comments: 06/8/2021 The record remains Non-Urgent. DWR DMP internal inspection has not found pipe integrity issues. LOF of crossing is less or equal to 4.0. Recommend next video inspection in 5 years. LS pipe inlet covered with vegetation, recommend removal. No permit was found authorizing this encroachment. CVFPB will need to review crossing to determine owner. The UCIP inspection was completed with GEI staff, P. Espinoza. (H. Dunn ? GEI) 04/18/2014
 Need to contact owner. Recommend clearing sediment deposit inside pipe. (O. Magana - DWR UCIP)
 FIELD_STRUCT_DESC: 24-inch corrugated metal gravity drainage pipe (CMP) through the levee, 10.7 feet below the crown. Flap gate on the waterside (WS) end. [Additional Reference(s): DWR Levee Log, 2002, (HLM 2.70). USACE San Joaquin O&M Manual, Unit No. 601, Part No. 1, 1967, Amended in 1978, Revised 20 June 1985, (HLM 2.70). DWR As-Built Specification No. 59-01, Sheet No. 62, 10 December 1958, (HLM 2.70)].

LS view: Close up of pipe inlet covered with vegetation.

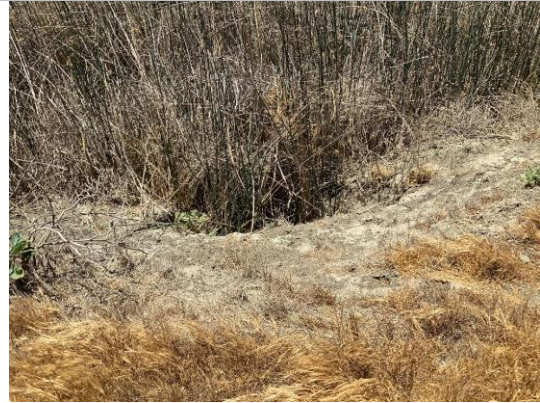
DS_ID:19861
FS_ID:73310
EP_NO: N/A
Repair Type: Non-Urgent
EVAL Issue: 11, Maintenance Compliance Issue
Crossing Status: Found
UCIP Comments: 06/8/2021 The record remains Non-Urgent. DWR DMP internal inspection has not found pipe integrity issues. LOF of crossing is less or equal to 4.0. Recommend next video inspection in 5 years. LS pipe inlet inaccessible due to barbed wire and WS flapgate surrounded by water, limited inspection for both. LS pipe inlet also has dense vegetation covering it, recommend removal. No permit was found authorizing this encroachment. CVFPB will need to review crossing to determine owner. The UCIP inspection was completed with GEI staff, P. Espinoza. (H. Dunn ? GEI)11/09/2015 DWR Inspection section confirmed issue has been addressed. Need to coordinate with LMA to determine additional details for extent of repair. (O. Magana - DWR UCIP)4/18/2014 Soil missing behind concrete headwall on waterward side. Unable to determine if missing soil is due to sink holes, rodent activity, or due to erosion. Headwall appears to be leaning slightly forward. Reason why this crossing was labelled urgent was due to the uncertainty of damage to concrete headwall and reason for soil missing behind concrete. Need to coordinate with LMA to determine more information about repair at this location. (O. Magana -DWR UCIP) FIELD_STRUCT_DESC: 24-inch corrugated metal gravity drainage pipe (CMP) through the levee, 2.0 feet below the crown. Flap gate on the waterside (WS) end. [Additional Reference(s): DWR Levee Log, 2002, (HLM 3.00). USACE San Joaquin O&M Manual, Unit No. 601, Part No. 1, 1967, Amended in 1978, Revised 20 June 1985, (HLM 3.00). DWR As-Built Specification No. 59-01, Sheet No. 63, 10 December 1958, (HLM 3.00)].

LS view: Top of headwall visible at toe.

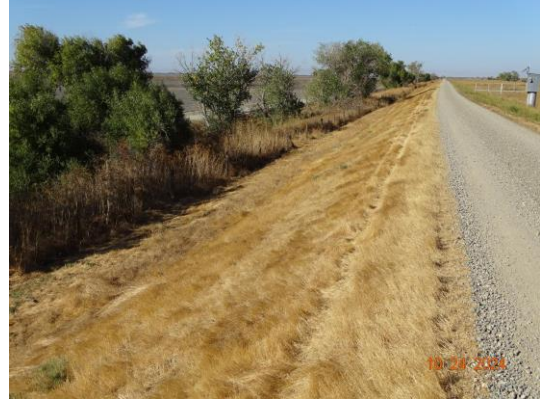
Photo 1 of 1 : FA_2024_NA0010_130_8_20241106_00016.jpg

LM Start	3.30	Rating **	A	Issue No.	8
LM End	3.30	Issue Type +	Ma	Location *	LS
Category	Earthen Levee	GPS Latitude/Longitude			
		Start		End	
Item	Vegetation	37.200929 °		37.200929 °	
		-120.695386 °		-120.695386 °	
DWR ID	DWR_NA0010_12_f _ 2024_8				
Comment Code					
V1 : Control annual grass and weeds on the levee slopes and easements.					
Inspector Comment					
Annual vegetation is well maintained.

Looking downstream at vegetation management on the landside slope.
(Fall 2024)

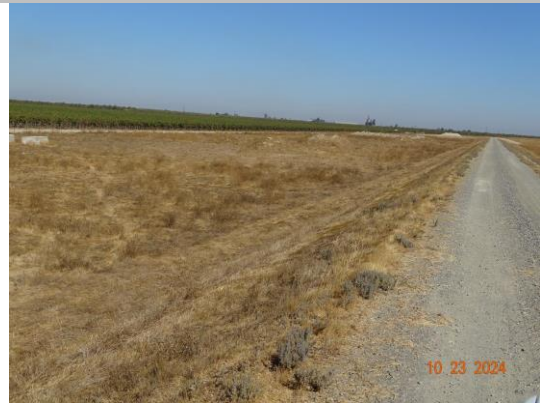
Photo 1 of 1 : FA_2024_NA0010_131_3_20241106_00012.jpg

LM Start	0.03	Rating **	A	Issue No.	3
LM End	0.03	Issue Type +	Ma	Location *	LS
Category	Earthen Levee			GPS Latitude/Longitude	
				Start	End
Item	Vegetation			37.034172 °	37.034172 °
				-120.441963 °	-120.441963 °
DWR ID	DWR_NA0010_13_f_2024_3				
Comment Code					
V1 : Control annual grass and weeds on the levee slopes and easements.					
Inspector Comment

View of good vegetation management on the landside slope. (Fall 2024)

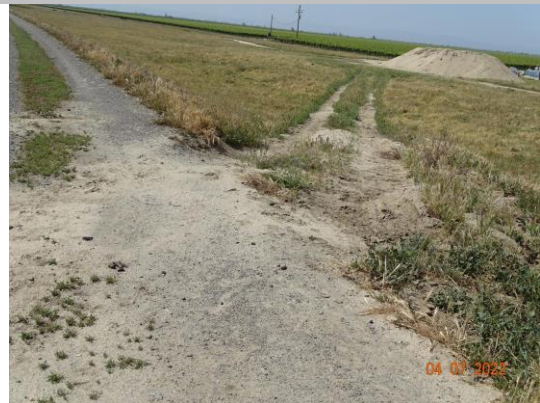
Photo 1 of 1 : FA_2024_NA0010_131_9_20240828_00005.jpg

LM Start	0.48	Rating **	A/W	Issue No.	9
LM End	0.48	Issue Type +	En	Location *	LS
Category	Earthen Levee			GPS Latitude/Longitude	
				Start	End
Item	Encroachments			37.040343 °	37.040343 °
				-120.439316 °	-120.439316 °
DWR ID	DWR_NA0010_13_f_2021_9				
Comment Code					
RA : Ramp					
Inspector Comment					
Vehicle traffic at unauthorized ramp is beginning to erode the levee shoulder. Continue to monitor.

Unauthorized ramp constructed on the landside slope. (Spring 2022)

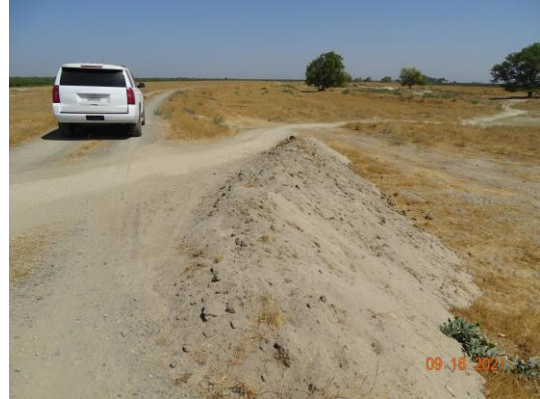
Photo 1 of 1 : FA_2024_NA0010_131_10_20240828_00006.jpg

LM Start	0.48	Rating **	A/W	Issue No.	10
LM End	0.48	Issue Type +	En	Location *	WS
Category	Earthen Levee			GPS Latitude/Longitude	
				Start	End
Item	Encroachments			37.040347 °	37.040347 °
				-120.439312 °	-120.439312 °
DWR ID	DWR_NA0010_13_f _ 2021_10				
Comment Code					
RA : Ramp					
Inspector Comment

View of unauthorized ramp on the waterside slope. (Fall 2021)

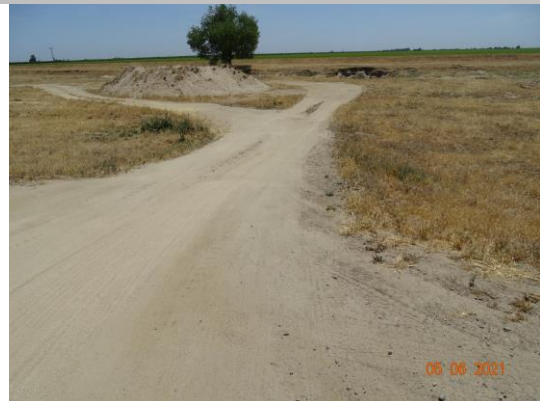
Photo 1 of 1 : FA_2024_NA0010_131_5_20240828_00001.jpg

LM Start	0.91	Rating **	M	Issue No.	5
LM End	0.91	Issue Type +	En	Location *	WS
Category	Earthen Levee			GPS Latitude/Longitude	
				Start	End
Item	Encroachments			37.044855 °	37.044855 °
				-120.434106 °	-120.434106 °
DWR ID	DWR_NA0010_13_s_2014_5				
Comment Code					
RA : Ramp					
Inspector Comment					
There is an unauthorized ramp on waterside slope. Access ramp on the landside is shown in as-built drawings.

Unauthorized ramp constructed on the waterside slope. (Spring 2021)

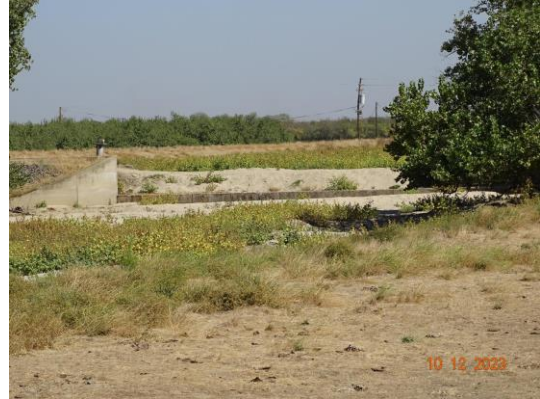
Photo 1 of 1 : FA_2024_NA0010_131_6_20240828_00002.jpg

LM Start	1.14	Rating **	A/W	Issue No.	6
LM End	1.14	Issue Type +	En	Location *	WS
Category	Earthen Levee			GPS Latitude/Longitude	
				Start	End
Item	Encroachments			37.045541 °	37.045541 °
				-120.430014 °	-120.430014 °
DWR ID	DWR_NA0010_13_f _ 2015_6				
Comment Code					
WL : Wall					
Inspector Comment					
The sand dam has been removed. Monitor for reinstallation of the dam.

Downstream view of sand dam constructed upstream of the Ash Slough Drop Structure 4. (Fall 2023)

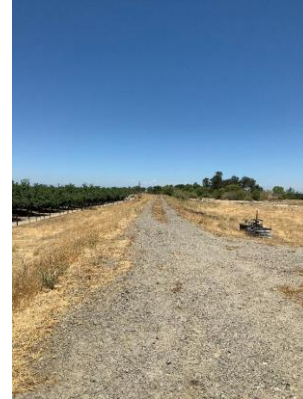
Photo 1 of 3 : UCIP_FA_2024_73336_103411.jpg

Comment Code						
Inspector Comment						
DS_ID:19727 FS_ID:73336 EP_NO: N/A Repair Type: Non-Urgent EVAL Issue: Crossing Status: Found UCIP Comments: 06/23/2021 The record remains Non-Urgent. Appears abandoned due to actuator missing on slidegate on the WS shoulder and if abandoned, should be done properly. Limited inspection of inlet and outlet due to standing water over concrete platforms surrounding pipe inlet/outlet, creating inability to inspect closely. No permit was found authorizing this encroachment. CVFPB will need to review crossing to determine owner. The UCIP inspection was completed with GEI staff, H.Dunn. (P.Espinoza ? GEI) 03/27/2014 Appears abandoned and if so should be done so properly. Pipe filled with soil on WS at outlet. Actuator missing from slide gate on WS shoulder. (W. Wylie - DWR UCIP) FIELD_STRUCT_DESC: [Rounder Irrigation Structure] 1 of 2: 36-inch corrugated metal gravity drainage pipe (CMP) through the levee, 12.3 feet below the crown. Slide gate in a 48-inch CMP riser unit on the waterside (WS) slope. 6-foot by 12-foot concrete distribution box on the landside (LS). 7-foot by 14-foot concrete outlet structure on the WS toe. [Additional Reference(s): DWR Levee Log, 2002, (HLM 1.14). USACE San Joaquin O&M Manual, Unit No. 601, Part No. 1, 1967, Amended in 1978, Revised 20 June 1985, (HLM 1.14). DWR As-Built Specification No. 64-01, Sheet No. 13, 6 November 1963, (HLM 1.14)]. FS Date: 6/23/2021 1:08:00 PM

View of levee crown.

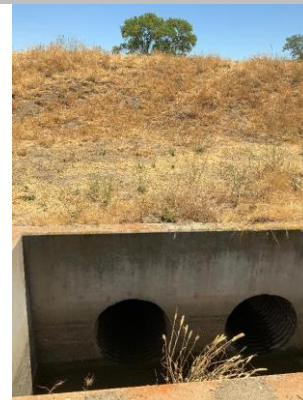
Photo 2 of 3 : UCIP_FA_2024_73336_103418.jpg

LS view: concrete inlet pipe on LS toe.

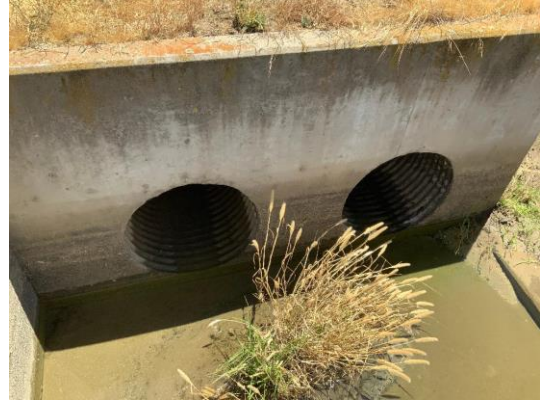
Photo 3 of 3 : UCIP_FA_2024_73336_103419.jpg

LM Start	1.14	Rating **	M	Issue No.	13 (cont)
LM End	1.14	Issue Type +	Ma	Location *	
Category	Supplemental			GPS Latitude/Longitude	
				Start	End
Item	DWR UCIP LMA Responsibility			37.045872 °	37.045872 °
				-120.430070 °	-120.430070 °
DWR ID	19727

LS view: close up of concrete inlet pipe on LS toe.

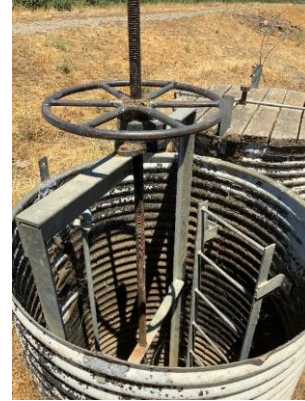
Photo 1 of 1 : UCIP_FA_2024_73337_103428.jpg

Comment Code					
Inspector Comment					
DS_ID:19908 FS_ID:73337 EP_NO: N/A Repair Type: Non-Urgent EVAL Issue: 4b, Safety Issue Crossing Status: Found UCIP Comments: 09/18/2023 Pipe was CIPP lined. DMP internal video inspection has found none or minor pipe defects. Recommend next video inspection in 5 years. (O. Yakimov - DWR UCIP) 06/23/2021 The record remains Non-Urgent. DWR DMP internal inspection has found pipe integrity issues. LOF of crossing is between 4.1 and 5. Crossing will be monitored until funding becomes available for rehabilitation. No lid on riser at WS shoulder, causing safety hazard. Limited inspection of both inlet and outlet due to standing water over concrete pads around the pipe inlet/out. Outlet also has metal grate over it, limiting ability to inspect pipe closely. No permit was found authorizing this encroachment. CVFPB will need to review crossing to determine owner. The UCIP inspection was completed with GEI staff, H.Dunn. (P.Espinoza ? GEI)03/27/2014 No lid on riser at WS shoulder could be safety issue. (W. Wylie - DWR UCIP) FIELD_STRUCT_DESC: [Rounder Irrigation Structure] 2 of 2: 36-inch CIPP-lined corrugated metal gravity drainage pipe (CMP) through the levee, 12.3 feet below the crown. Slide gate in a 48-inch CMP riser unit on the waterside (WS) slope. 6-foot by 12-foot concrete distribution box on the landside (LS). 7-foot by 14-foot concrete outlet structure on the WS toe. [Additional Reference(s): DWR Levee Log, 2002, (HLM 1.14). USACE San Joaquin O&M Manual, Unit No. 601, Part No. 1, 1967, Amended in 1978, Revised 20 June 1985, (HLM 1.14). DWR As-Built Specification No. 64-01, Sheet No. 13, 6 November 1963, (HLM 1.14)]. FS Date: 6/23/2021 2:23:00 PM

WS view: close up of CMP riser.

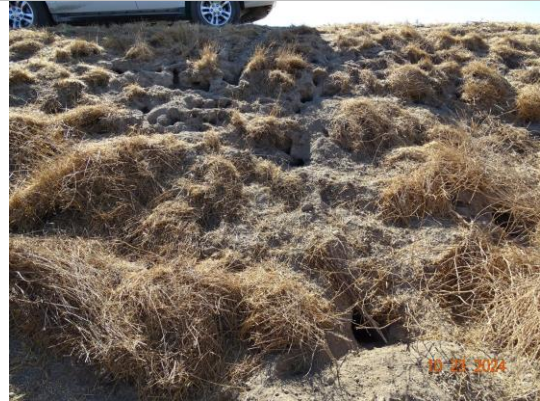
Photo 1 of 1 : FA_2024_NA0010_131_7_20241106_00013.jpg

LM Start	1.19	Rating **	U	Issue No.	7
LM End	1.24	Issue Type +	Ma	Location *	LS
Category	Earthen Levee			GPS Latitude/Longitude	
				Start	End
Item	Animal Control			37.046096°	37.046229°
				-120.429188°	-120.428448°
DWR ID	DWR_NA0010_13_f_2022_7				
Comment Code					
A3 : No rodents visible, but rodent burrows visible; need to backfill and compact or grout burrows.					
Inspector Comment

Several rodent burrows observed in this section. (Fall 2024)

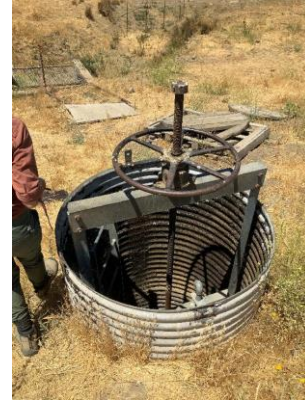
Photo 1 of 1 : UCIP_FA_2024_73338_103435.jpg

Comment Code						
Inspector Comment						
DS_ID:19909 FS_ID:73338 EP_NO: N/A Repair Type: Non-Urgent EVAL Issue: 4b, Safety Issue Crossing Status: Found UCIP Comments: 06/23/2021 The record remains Non-Urgent. DWR DMP internal inspection has found pipe integrity issues. LOF of crossing is between 4.1 and 5. Crossing will be monitored until funding becomes available for rehabilitation. CMP riser on WS slope is missing lid, causing a safety concern. Limited inspection of both inlet and outlet due to elevated standing water in concrete boxes surrounding inlet/outlet, limiting closeup inspection of pipe. No permit was found authorizing this encroachment. CVFPB will need to review crossing to determine owner. The UCIP inspection was completed with GEI staff, H.Dunn. (P.Espinoza ? GE03/27/2014 Lid should be installed on CMP riser on WS slope, could be a safety hazard. Also dense vegetation limits the inspector's visibility to identify signs of pipe failure (leaks) along the slope. Recommend removing vegetation along pipe alignment to conduct proper inspection of structure. (O. Magana - DWR UCIP) FIELD_STRUCT_DESC: [Rounder Irrigation Structure] 36-inch corrugated metal gravity irrigation pipe (CMP) through the levee, 10.0 feet below the crown. Slide gate in a 48-inch CMP riser unit on the waterside (WS) slope. 6-foot by 7-foot concrete distribution box at the WS toe. Slots for wooden flashboards on the WS of the box. 7-foot by 9-foot concrete distribution box on the landside (LS), 20 feet from the toe. [Additional Reference(s): DWR Levee Log, 2002, (HLM 1.15). USACE San Joaquin O&M Manual, Unit No. 601, Part No. 1, 1967, Amended in 1978, Revised 20 June 1985, (HLM 1.15). DWR As-Built Specification No. 64-01, Sheet No. 13, 6 November 1963, (HLM 1.15)]. FS Date: 6/23/2021

WS view: Slide gate in CMP riser on shoulder.

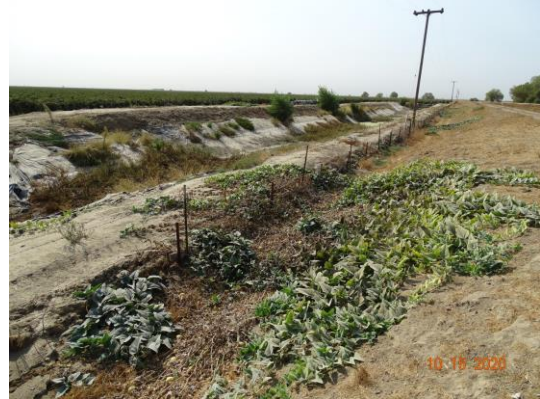
Photo 1 of 1 : FA_2024_NA0010_132_3_20240828_00001.jpg

LM Start	1.15	Rating **	A/W	Issue No.	3
LM End	1.26	Issue Type +	En	Location *	LS
Category	Earthen Levee			GPS Latitude/Longitude	
				Start	End
Item	Encroachments			37.044939 °	37.045416 °
				-120.429636 °	-120.427719 °
DWR ID	DWR_NA0010_14_f _ 2020_3				
Comment Code					
DT : Ditch					
Inspector Comment					
Retention pond dug approx. 20 feet from landside toe. Monitor.

Retention basin dug approximately 20 ft from the landside toe. (Fall 2020)

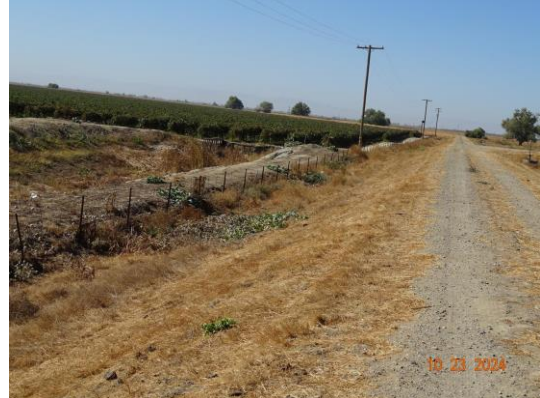
Photo 1 of 1 : FA_2024_NA0010_132_6_20241106_00006.jpg

LM Start	1.16	Rating **	A	Issue No.	6
LM End	1.16	Issue Type +	Ma	Location *	LS
Category	Earthen Levee			GPS Latitude/Longitude	
				Start	End
Item	Vegetation			37.044954 °	37.044954 °
				-120.429518 °	-120.429518 °
DWR ID	DWR_NA0010_14_f_2024_6				
Comment Code					
V1 : Control annual grass and weeds on the levee slopes and easements.					
Inspector Comment					
Annual vegetation is well maintained.

Looking downstream along the landside slope. (Fall 2024)

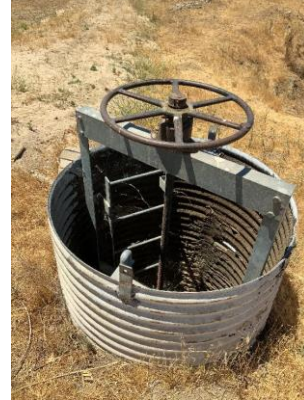
Photo 1 of 1 : UCIP_FA_2024_84910_103812.jpg

Comment Code						
Inspector Comment						
DS_ID:19910 FS_ID:84910 EP_NO: N/A Repair Type: Non-Urgent EVAL Issue: 4b, Safety Issue Crossing Status: Found UCIP Comments: 12/20/2022 Record updated from Urgent to Non-Urgent. Pipe has been CIPP lined. LOF of crossing is less or equal to 4. Recommend next video inspection in 5 years. (O.Yakimov - DWR UCIP) 06/23/2021 Record has been upgraded from No Action Needed to Urgent. DWR DMP internal inspection has found pipe integrity issues. LOF of crossing is between 5 and 6. Crossing will be monitored until funding becomes available to address the issues. Lid missing from CMP riser on WS slope, causing safety concern. LS not accessible; limited inspection due to barbed wire. No permit was found authorizing this encroachment. CVFPB will need to review crossing to determine owner. The UCIP inspection was completed with GEI staff, H.Dunn. (P.Espinoza ? GEI) FIELD_STRUCT_DESC: 36-inch CIPP-lined corrugated metal gravity drainage pipe (CMP) through the levee, 9.0 feet below the crown. Slide gate in a 42-inch CMP riser unit on the waterside (WS) slope. Concrete U-shaped headwall on the WS end. Pipe terminates into a concrete ditch on the landside (LS). [Additional Reference(s): DWR Levee Log, 2002, (HLM 1.26). USACE San Joaquin O&M Manual, Unit No. 601, Part No. 1, 1967, Amended in 1978, Revised 20 June 1985, (HLM 1.26). DWR As-Built Specification No. 64-01, Sheet No. 13, 6 November 1963, (HLM 1.26)]. FS Date: 6/23/2021 10:53:01 AM

WS view: close up of CMP riser on slope.

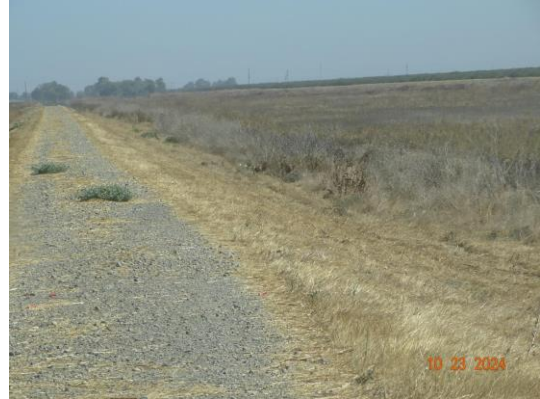
Photo 1 of 1 : FA_2024_NA0010_133_5_20241106_00007.jpg

LM Start	0.04	Rating **	A	Issue No.	5
LM End	0.04	Issue Type +	Ma	Location *	WS
Category	Earthen Levee			GPS Latitude/Longitude	
				Start	End
Item	Vegetation			36.996563 °	36.996563 °
				-120.409678 °	-120.409678 °
DWR ID	DWR_NA0010_15_f _ 2024_5				
Comment Code					
V1 : Control annual grass and weeds on the levee slopes and easements.					
Inspector Comment					
The annual vegetation is well maintained.

Looking upstream along the waterside slope. (Fall 2024)

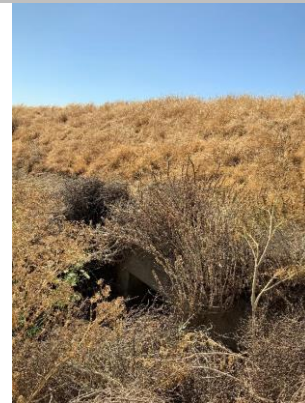
Photo 1 of 1 : UCIP_FA_2024_73365_103819.jpg

LM Start	0.48	Rating **	M	Issue No.	7	
LM End	0.48	Issue Type +	Ma	Location *		
Category	Supplemental			GPS Latitude/Longitude		
				Start		End
Item	DWR UCIP LMA Responsibility			36.996551 °		36.996551 °
				-120.401737 °		-120.401737 °
DWR ID	19911

Comment Code						
Inspector Comment						
DS_ID:19911 FS_ID:73365 EP_NO: N/A Repair Type: Non-Urgent EVAL Issue: 11, Maintenance Compliance Issue Crossing Status: Indicator Found UCIP Comments: 06/24/2021 The record has been upgraded from No Action Needed to Non-Urgent. Limited inspection of LS due to vegetation overgrowth; recommend removal. Water was actively flowing through WS pipe. No permit was found authorizing this encroachment. CVFPB will need to review crossing to determine owner. The UCIP inspection was completed with GEI staff, H.Dunn. (P.Espinoza ? GEI) FIELD_STRUCT_DESC: 30-inch by 30-inch square reinforced concrete box gravity drainage culvert (RCBC) through the levee, 10.1 feet below the crown. Flap gate on the waterside (WS) end. Concrete headwall on the landside (LS) end. Concrete U-shaped headwall on the WS end. [Additional Reference(s): DWR Levee Log, 2002, (HLM 0.49). USACE San Joaquin O&M Manual, Unit No. 601, Part No. 1, 1967, Amended in 1978, Revised 20 June 1985, (HLM 0.48). DWR As-Built Specification No. 64-42, Sheet No. 23, 13 August 1964, (HLM 0.48)]. FS Date: 6/24/2021 2:52:00 PM

LS view: concrete wall and entrance to pipe from toe. View of slope in background.

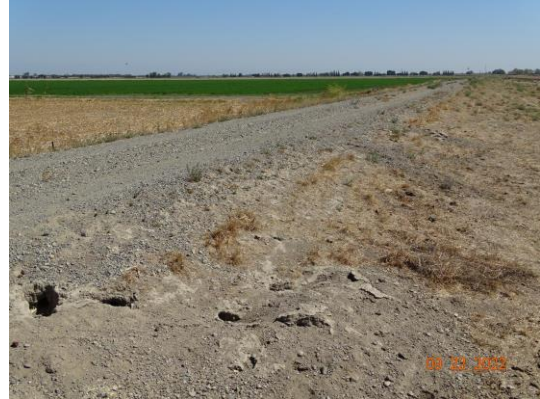
Photo 1 of 1 : FA_2024_NA0010_133_6_20240828_00002.jpg

LM Start	0.95	Rating **	M	Issue No.	6
LM End	0.95	Issue Type +	Ma	Location *	WS
Category	Earthen Levee			GPS Latitude/Longitude	
				Start	End
Item	Animal Control			36.996555 °	36.996555 °
				-120.393195 °	-120.393195 °
DWR ID	DWR_NA0010_15_s_2022_6				
Comment Code					
A1 : Exterminate rodents and backfill and compact or grout burrows.					
Inspector Comment					
Burrows on both landside and waterside slopes.

View of rodent holes in the waterside slope. (Fall 2022)

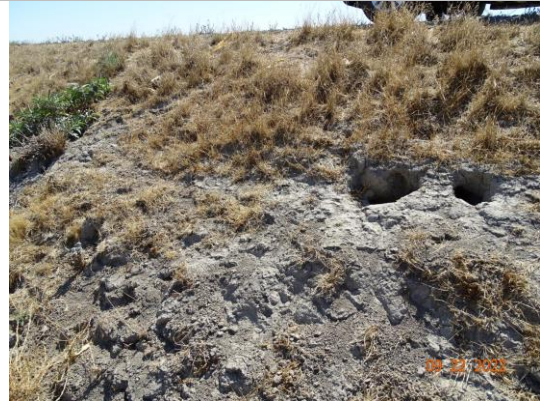
Photo 1 of 1 : FA_2024_NA0010_133_4_20240828_00001.jpg

LM Start	0.96	Rating **	M	Issue No.	4
LM End	0.96	Issue Type +	Ma	Location *	LS
Category	Earthen Levee			GPS Latitude/Longitude	
				Start	End
Item	Animal Control			36.996557 °	36.996557 °
				-120.393095 °	-120.393095 °
DWR ID	DWR_NA0010_15_f_2022_4				
Comment Code					
A3 : No rodents visible, but rodent burrows visible; need to backfill and compact or grout burrows.					
Inspector Comment

View of rodent holes on the landside slope. (Fall 2022)

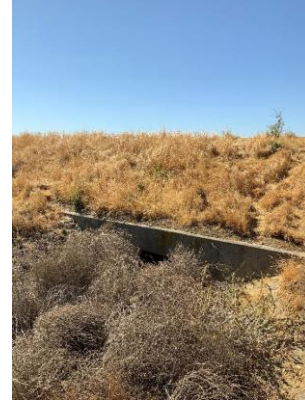
Photo 1 of 1 : UCIP_FA_2024_73366_103825.jpg

Comment Code						
Inspector Comment						
DS_ID:19912 FS_ID:73366 EP_NO: N/A Repair Type: Non-Urgent EVAL Issue: 11, Maintenance Compliance Issue Crossing Status: Found UCIP Comments: 06/24/2021 The record remains Non-Urgent. Limited inspection of LS pipe due to vegetation overgrowth; recommend removal. No permit was found authorizing this encroachment. CVFPB will need to review crossing to determine owner. The UCIP inspection was completed with GEI staff, H.Dunn. (P.Espinoza ? GEI) 03/27/2014 Dense vegetation limits the inspector's visibility to identify signs of pipe failure (leaks) along the landward slope. Recommend removing vegetation along pipe alignment to conduct proper inspection of structure. (W. Wylie - DWR UCIP) FIELD_STRUCT_DESC: 30-inch by 30-inch square reinforced concrete box gravity drainage culvert (RCBC) through the levee, 8.5 feet below the crown. Flap gate on the waterside (WS) end. Concrete headwall on the landside (LS) end. Concrete U-shaped headwall on the WS end. [Additional Reference(s): DWR Levee Log, 2002, (HLM 1.01). USACE San Joaquin O&M Manual, Unit No. 601, Part No. 1, 1967, Amended in 1978, Revised 20 June 1985, (HLM 1.01). DWR As-Built Specification No. 64-42, Sheet No. 23, 13 August 1964, (HLM 1.01)]. FS Date: 6/24/2021 3:18:00 PM

LS view: concrete headwall on toe.

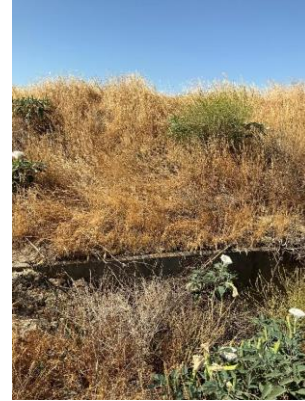
Photo 1 of 2 : UCIP_FA_2024_73367_103831.jpg

Comment Code						
Inspector Comment						
DS_ID:19913 FS_ID:73367 EP_NO: N/A Repair Type: Non-Urgent EVAL Issue: 11, Maintenance Compliance Issue Crossing Status: Found UCIP Comments: 06/24/2021 The record remains Non-Urgent. Limited inspection of LS pipe due to vegetation overgrowth; recommend removal. Note that wooden board is holding flapgate closed on WS; recommend removing before flood season to allow for flow. No permit was found authorizing this encroachment. CVFPB will need to review crossing to determine owner. The UCIP inspection was completed with GEI staff, H.Dunn. (P.Espinoza ? GEI)03/27/2014 Excessive vegetation at inlet on LS toe. (W. Wylie - DWR UCIP) FIELD_STRUCT_DESC: 30-inch by 30-inch square reinforced concrete box gravity drainage culvert (RCBC) through the levee, 8.9 feet below the crown. Flap gate on the waterside (WS) end. Concrete headwall on the landside (LS) end. Concrete U-shaped headwall on the WS end. [Additional Reference(s): DWR Levee Log, 2002, (HLM 1.54). USACE San Joaquin O&M Manual, Unit No. 601, Part No. 1, 1967, Amended in 1978, Revised 20 June 1985, (HLM 1.53). DWR As-Built Specification No. 64-42, Sheet No. 24, 13 August 1964, (HLM 1.53)]. FS Date: 6/24/2021 3:47:00 PM

LS view: concrete headwall from toe.

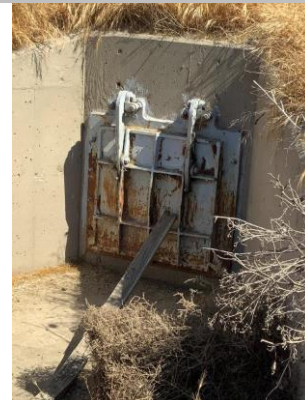
Photo 2 of 2 : UCIP_FA_2024_73367_103833.jpg

WS view: closeup of flapgate.

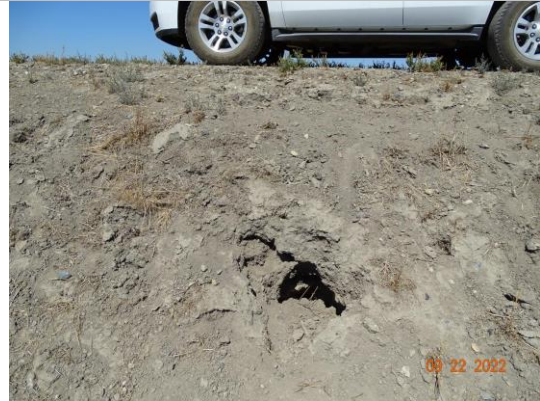
Photo 1 of 1 : FA_2024_NA0010_134_7_20240828_00003.jpg

LM Start	0.22	Rating **	M	Issue No.	7
LM End	0.22	Issue Type +	Ma	Location *	LS
Category	Earthen Levee			GPS Latitude/Longitude	
				Start	End
Item	Animal Control			36.995421 °	36.995421 °
				-120.404956 °	-120.404956 °
DWR ID	DWR_NA0010_16_f_2022_7				
Comment Code					
A3 : No rodents visible, but rodent burrows visible; need to backfill and compact or grout burrows.					
Inspector Comment

Animal burrows on the landside slope. (Fall 2022)

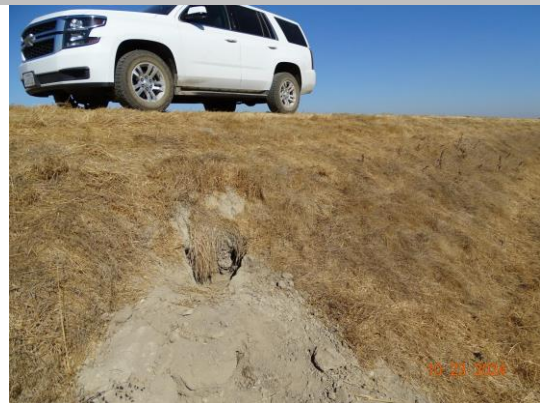
Photo 1 of 1 : FA_2024_NA0010_134_10_20241106_00009.jpg

LM Start	0.30	Rating **	U	Issue No.	10
LM End	0.30	Issue Type +	Ma	Location *	LS
Category	Earthen Levee			GPS Latitude/Longitude	
				Start	End
Item	Animal Control			36.995433 °	36.995433 °
				-120.403543 °	-120.403543 °
DWR ID	DWR_NA0010_16_s_2022_10				
Comment Code					
A3 : No rodents visible, but rodent burrows visible; need to backfill and compact or grout burrows.					
Inspector Comment					
Burrow is approximately 18-inches across.

Large animal burrow on the landside slope. (Fall 2024)

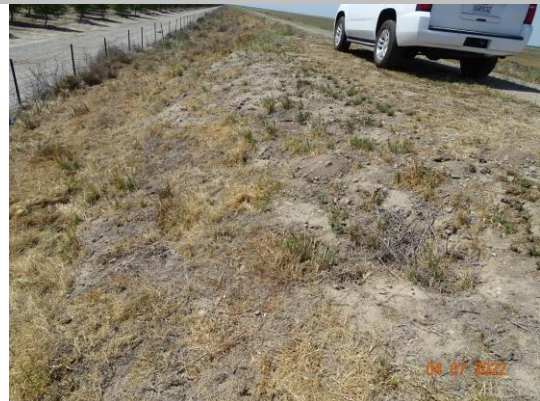
Photo 1 of 1 : FA_2024_NA0010_134_92_20240828_00006.jpg

LM Start	0.93	Rating **	M	Issue No.	92
LM End	0.93	Issue Type +	Ma	Location *	LS
Category	Earthen Levee			GPS Latitude/Longitude	
				Start	End
Item	Animal Control			36.995439 °	36.995439 °
				-120.392146 °	-120.392146 °
DWR ID	DWR_NA0010_16_s_2015_92				
Comment Code					
A3 : No rodents visible, but rodent burrows visible; need to backfill and compact or grout burrows.					
Inspector Comment					
Several rodent holes are identified within this section.

Looking at several rodent holes on landward slope. (Spring 2022)

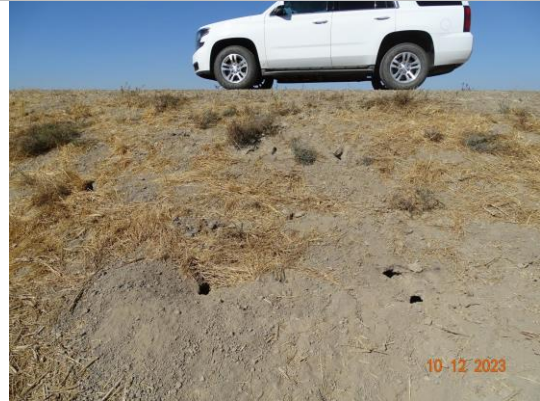
Photo 1 of 1 : FA_2024_NA0010_134_5_20240828_00002.jpg

LM Start	1.27	Rating **	M	Issue No.	5
LM End	1.27	Issue Type +	Ma	Location *	LS
Category	Earthen Levee			GPS Latitude/Longitude	
				Start	End
Item	Animal Control			36.995461 °	36.995461 °
				-120.386068 °	-120.386068 °
DWR ID	DWR_NA0010_16_f _ 2023_5				
Comment Code					
A3 : No rodents visible, but rodent burrows visible; need to backfill and compact or grout burrows.					
Inspector Comment

Multiple rodent burrows in the landside slope. (Fall 2023)

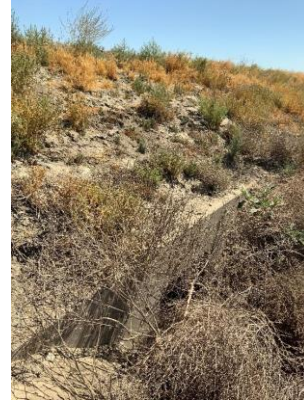
Photo 1 of 2 : UCIP_FA_2024_73370_103851.jpg

Comment Code					
Inspector Comment					
DS_ID:19915 FS_ID:73370 EP_NO: N/A Repair Type: Non-Urgent EVAL Issue: 11, Maintenance Compliance Issue Crossing Status: Found UCIP Comments: 06/24/2021 The record remains Non-Urgent. Limited inspection on LS and WS due to vegetation overgrowth, recommend removal. No permit was found authorizing this encroachment. CVFPB will need to review crossing to determine owner. The UCIP inspection was completed with GEI staff, H.Dunn. (P.Espinoza ? GEI) 04/01/2014 Dense vegetation buildup at landside toe--recommend clearing. (W. Wylie - DWR UCIP) FIELD_STRUCT_DESC: 30-inch by 30-inch square reinforced concrete box gravity drainage culvert (RCBC) through the levee, 8.5 feet below the crown. Two concrete cutoff walls. Flap gate on the waterside (WS) end. Concrete headwall on the landside (LS) end. Concrete U-shaped headwall on the WS end. [Additional Reference(s): DWR Levee Log, 2002, (HLM 1.46). USACE San Joaquin O&M Manual, Unit No. 601, Part No. 1, 1967, Amended in 1978, Revised 20 June 1985, (HLM 1.46). DWR As-Built Specification No. 64-42, Sheet No. 24, 13 August 1964, (HLM 1.46)]. FS Date: 6/24/2021 11:09:00 AM

LS view: Slope and concrete headwall at inlet, covered by heavy vegetation.

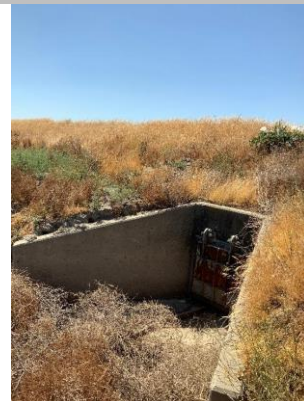
Photo 2 of 2 : UCIP_FA_2024_73370_103849.jpg

WS view: Slope, flapgate, and concrete headwall at toe.

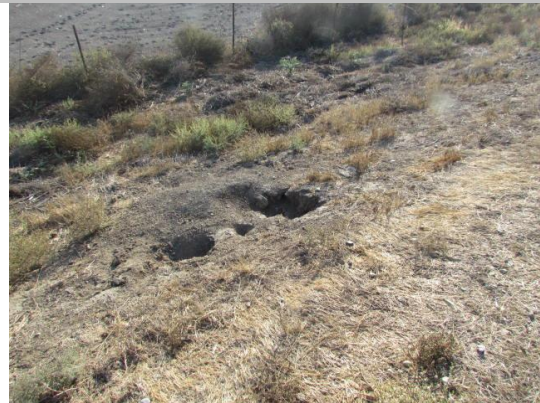
Photo 1 of 1 : FA_2024_NA0010_134_2_20240828_00001.jpg

LM Start	1.77	Rating **	U	Issue No.	2
LM End	1.77	Issue Type +	Ma	Location *	LS
Category	Earthen Levee			GPS Latitude/Longitude	
				Start	End
Item	Animal Control			36.995487 °	36.995487 °
				-120.377054 °	-120.377054 °
DWR ID	DWR_NA0010_16_f_2014_2				
Comment Code					
A3 : No rodents visible, but rodent burrows visible; need to backfill and compact or grout burrows.					
Inspector Comment					
Large rodent holes are on the landside slope.

Looking southwest at several rodent holes on landward slope.

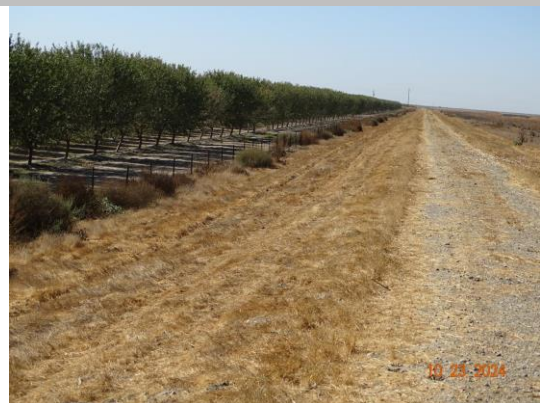
Photo 1 of 1 : FA_2024_NA0010_134_3_20241106_00011.jpg

LM Start	1.91	Rating **	A	Issue No.	3
LM End	1.91	Issue Type +	Ma	Location *	LS
Category	Earthen Levee			GPS Latitude/Longitude	
				Start	End
Item	Vegetation			36.995475 °	36.995475 °
				-120.374545 °	-120.374545 °
DWR ID	DWR_NA0010_16_f_2024_3				
Comment Code					
V1 : Control annual grass and weeds on the levee slopes and easements.					
Inspector Comment

View of the good vegetation management on the landside slope. (Fall 2024)

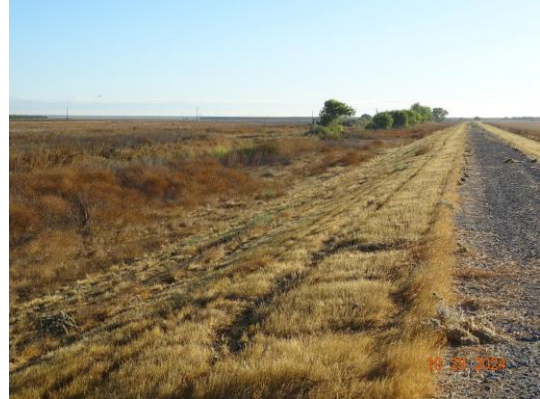
Photo 1 of 1 : FA_2024_NA0010_135_11_20241106_00023.jpg

LM Start	0.03	Rating **	A	Issue No.	11
LM End	0.03	Issue Type +	Ma	Location *	LS
Category	Earthen Levee			GPS Latitude/Longitude	
				Start	End
Item	Vegetation			36.976457 °	36.976457 °
				-120.374133 °	-120.374133 °
DWR ID	DWR_NA0010_17_f_2024_11				
Comment Code					
V1 : Control annual grass and weeds on the levee slopes and easements.					
Inspector Comment

View of vegetation management on the landside slope. (Fall 2024)

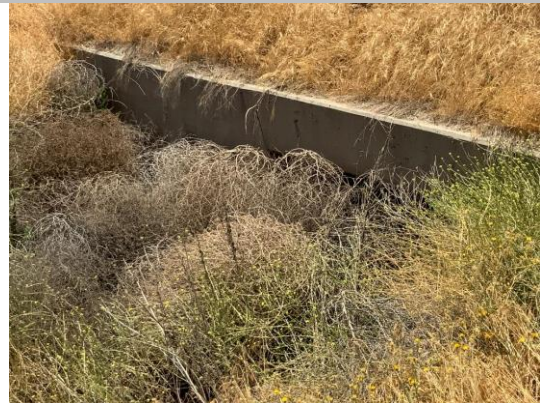
Photo 1 of 1 : UCIP_FA_2024_73434_102398.jpg

Comment Code						
Inspector Comment						
DS_ID:19916 FS_ID:73434 EP_NO: N/A Repair Type: Non-Urgent EVAL Issue: 11, Maintenance Compliance Issue Crossing Status: Found UCIP Comments: 07/13/2021 The record remains Non-Urgent. Limited inspection due to tumbleweeds blocking LS pipe inlet, recommend removal. No permit was found authorizing this encroachment. CVFPB will need to review crossing to determine owner. The UCIP inspection was completed with GEI staff, P. Espinoza. (H. Dunn ? GEI) 04/01/2014 Dense vegetation limits the inspector's visibility to identify signs of pipe failure (leaks) along the landward slope. Recommend removing vegetation along pipe alignment to conduct proper inspection of structure. (W. Wylie - DWR UCIP) FIELD_STRUCT_DESC: 48-inch by 60-inch reinforced concrete box gravity drainage culvert (RCBC) through the levee, 14.6 feet below the crown. Flap gate on the waterside (WS) end. Concrete headwall on the landside (LS) end. Concrete U-shaped headwall on the WS end. [Additional Reference(s): DWR Levee Log, 2002, (HLM 2.58). USACE San Joaquin O&M Manual, Unit No. 601, Part No. 1, 1967, Amended in 1978, Revised 20 June 1985, (HLM 2.58). DWR As-Built Specification No. 64-42, Sheet No. 13, 13 August 1964, (HLM 2.58)]. FS Date: 7/19/2021

LS view: Tumbleweeds blocking pipe inlet at toe.

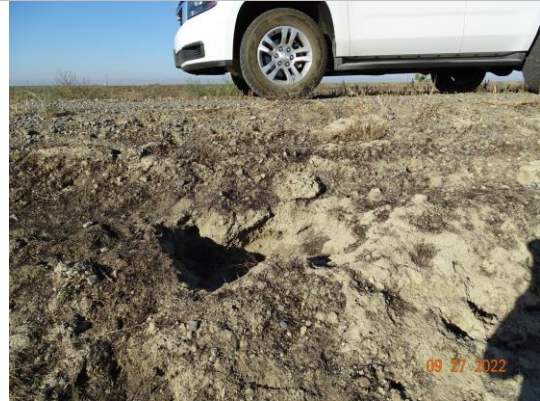
Photo 1 of 1 : FA_2024_NA0010_135_21_20240828_00011.jpg

LM Start	2.88	Rating **	M	Issue No.	21
LM End	2.88	Issue Type +	Ma	Location *	LS
Category	Earthen Levee			GPS Latitude/Longitude	
				Start	End
Item	Animal Control			36.948301 °	36.948301 °
				-120.346357 °	-120.346357 °
DWR ID	DWR_NA0010_17_f_2022_21				
Comment Code					
A3 : No rodents visible, but rodent burrows visible; need to backfill and compact or grout burrows.					
Inspector Comment					
Depression in the landside slope appears to be caused by collapsed rodent burrows. Recommend backfilling and compacting.

Representative animal burrow on the landside slope. (Fall 2022)

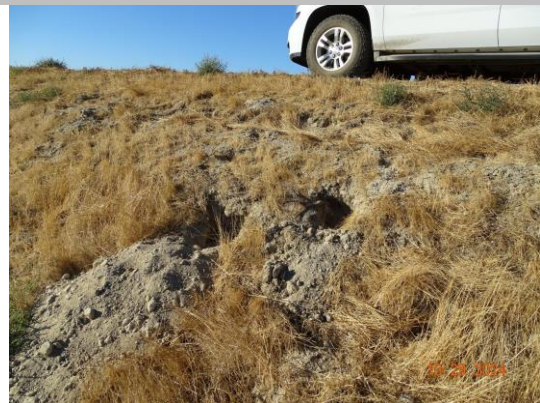
Photo 1 of 1 : FA_2024_NA0010_135_13_20241106_00024.jpg

LM Start	4.26	Rating **	M	Issue No.	13
LM End	4.26	Issue Type +	Ma	Location *	LS
Category	Earthen Levee			GPS Latitude/Longitude	
				Start	End
Item	Animal Control			36.929198 °	36.929198 °
				-120.338668 °	-120.338668 °
DWR ID	DWR_NA0010_17_f_2024_13				
Comment Code					
A3 : No rodents visible, but rodent burrows visible; need to backfill and compact or grout burrows.					
Inspector Comment					
Rodent holes are partially collapsed.

Rodent burrows on the landside slope. (Fall 2024)

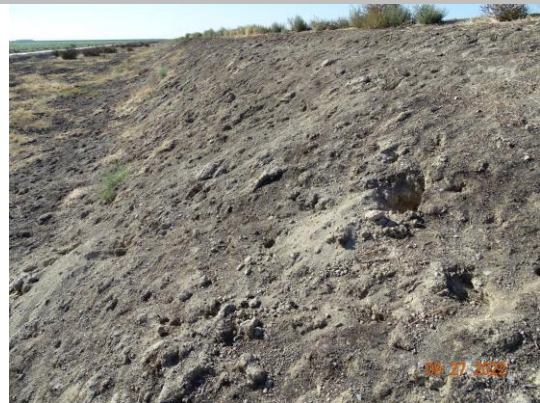
Photo 1 of 1 : FA_2024_NA0010_135_5_20240828_00003.jpg

LM Start	7.27	Rating **	M	Issue No.	5
LM End	7.38	Issue Type +	Ma	Location *	LS
Category	Earthen Levee			GPS Latitude/Longitude	
				Start	End
Item	Animal Control			36.887852 °	36.886388 °
				-120.321668 °	-120.320950 °
DWR ID	DWR_NA0010_17_s_2012_5				
Comment Code					
A3 : No rodents visible, but rodent burrows visible; need to backfill and compact or grout burrows.					
Inspector Comment					
Several rodent holes are identified within this reach.

Looking at typical view of rodent holes on landward slope. (Fall 2022)

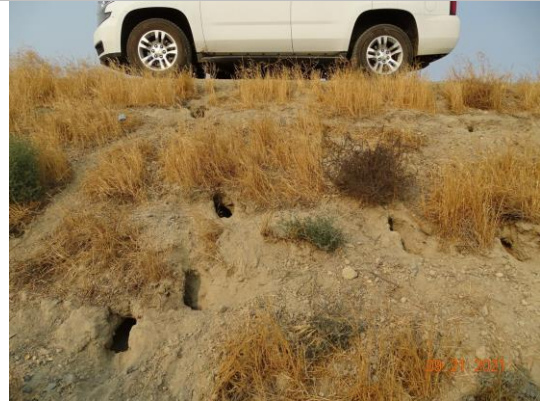
Photo 1 of 1 : FA_2024_NA0010_135_18_20240828_00009.jpg

LM Start	7.74	Rating **	U	Issue No.	18
LM End	7.74	Issue Type +	Ma	Location *	LS
Category	Earthen Levee			GPS Latitude/Longitude	
				Start	End
Item	Animal Control			36.881470 °	36.881470 °
				-120.318961 °	-120.318961 °
DWR ID	DWR_NA0010_17_f _ 2021_18				
Comment Code					
A3 : No rodents visible, but rodent burrows visible; need to backfill and compact or grout burrows.					
Inspector Comment

Looking up the landside slope at several rodent holes. (Fall 2021)

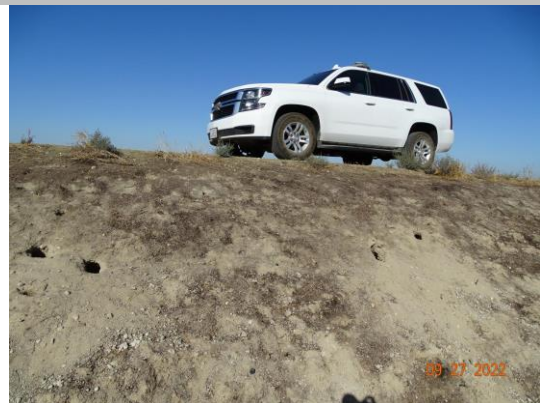
Photo 1 of 1 : FA_2024_NA0010_135_24_20240828_00012.jpg

LM Start	8.15	Rating **	M	Issue No.	24
LM End	8.15	Issue Type +	Ma	Location *	LS
Category	Earthen Levee			GPS Latitude/Longitude	
				Start	End
Item	Animal Control			36.875525 °	36.875525 °
				-120.317788 °	-120.317788 °
DWR ID	DWR_NA0010_17_f_2017_24				
Comment Code					
A3 : No rodents visible, but rodent burrows visible; need to backfill and compact or grout burrows.					
Inspector Comment					
Rodent holes are on the landside and crown of levee. Rodent holes have caused some erosion on the landside slope.

Looking east at the landside slope. (Fall 2022)

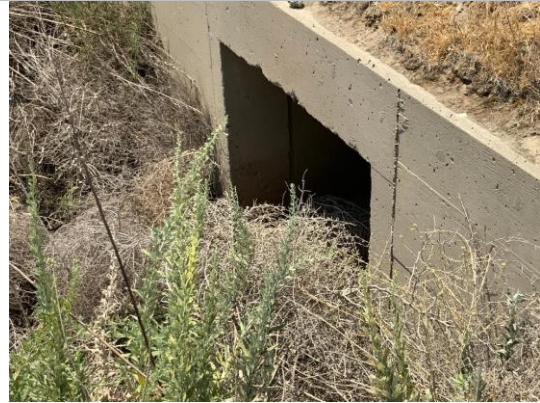
Photo 1 of 1 : UCIP_FA_2024_73437_102420.jpg

Comment Code						
Inspector Comment						
DS_ID:19922 FS_ID:73437 EP_NO: N/A Repair Type: Non-Urgent EVAL Issue: 11, Maintenance Compliance Issue Crossing Status: Found UCIP Comments: 07/13/2021 The record has been upgraded from No Action Needed to Non-Urgent. Limited inspection due to dense tumbleweeds over LS pipe inlet, recommend removal. No permit was found authorizing this encroachment. CVFPB will need to review crossing to determine owner. The UCIP inspection was completed with GEI staff, P. Espinoza. (H. Dunn ? GEI) FIELD_STRUCT_DESC: 48-inch by 60-inch reinforced concrete box gravity drainage culvert (RCBC) through the levee, 16.5 feet below the crown. Flap gate on the waterside (WS) end. Concrete headwall on the landside (LS) end. Concrete U-shaped headwall on the WS end. [Additional Reference(s): DWR Levee Log, 2002, (HLM 8.38). USACE San Joaquin O&M Manual, Unit No. 601, Part No. 1, 1967, Amended in 1978, Revised 20 June 1985, (HLM 8.38). DWR As-Built Specification No. 64-42, Sheet No. 17, 13 August 1964, (HLM 8.38)]. FS Date: 7/19/2021

LS view: Closeup of pipe inlet at toe.

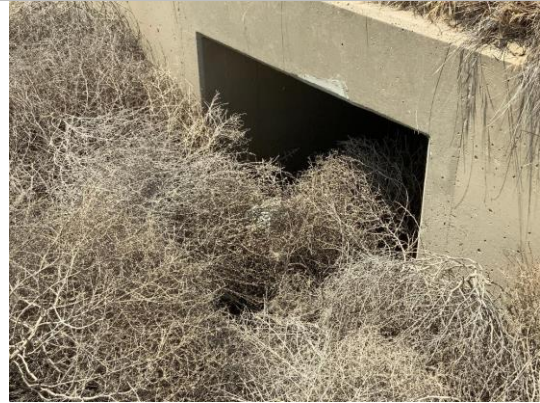
Photo 1 of 1 : UCIP_FA_2024_73439_102427.jpg

Comment Code						
Inspector Comment						
DS_ID:19917 FS_ID:73439 EP_NO: N/A Repair Type: Non-Urgent EVAL Issue: 5, Pipe Damage Crossing Status: Found UCIP Comments: 09/25/2024 DMP internal video inspection has found moderate pipe defects. Crossing will be monitored until funding becomes available for rehabilitation. (O. Yakimov - DWR UCIP) 07/13/2021 The record remains Non-Urgent. Limited inspection due to dense tumbleweeds over LS pipe inlet, recommend removal. No permit was found authorizing this encroachment. CVFPB will need to review crossing to determine owner. The UCIP inspection was completed with GEI staff, P. Espinoza. (H. Dunn ? GEI)04/01/2014 Dense vegetation limits the inspector's visibility to identify signs of pipe failure (leaks) along the landward slope. Recommend removing vegetation along pipe alignment to conduct proper inspection of structure. (W. Wylie - DWR UCIP) FIELD_STRUCT_DESC: 48-inch by 60-inch reinforced concrete box gravity drainage culvert (RCBC) through the levee, 15.0 feet below the crown. Concrete headwall on the landside (LS) end. Concrete U-shaped headwall on the waterside (WS) end. [Additional Reference(s): DWR Levee Log, 2002, (HLM 9.89). USACE San Joaquin O&M Manual, Unit No. 601, Part No. 1, 1967, Amended in 1978, Revised 20 June 1985, (HLM 9.89). DWR As-Built Specification No. 64-42, Sheet No. 18, 13 August 1964, (HLM 9.89)]. FS Date: 7/19/2021

LS view: Closeup of inlet at toe covered by tumbleweeds.

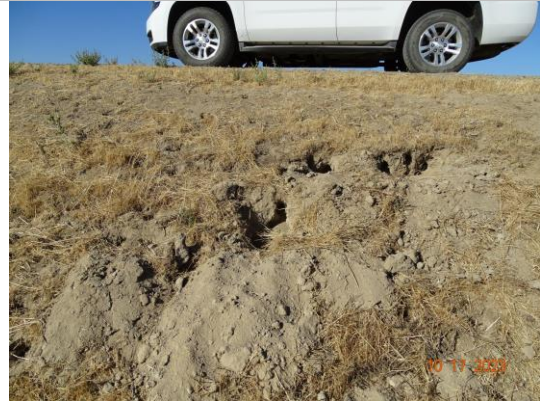
Photo 1 of 1 : FA_2024_NA0010_135_15_20240828_00006.jpg

LM Start	9.92	Rating **	M	Issue No.	15
LM End	9.92	Issue Type +	Ma	Location *	LS
Category	Earthen Levee			GPS Latitude/Longitude	
				Start	End
Item	Animal Control			36.850063 °	36.850063 °
				-120.314122 °	-120.314122 °
DWR ID	DWR_NA0010_17_f _ 2023_15				
Comment Code					
A3 : No rodents visible, but rodent burrows visible; need to backfill and compact or grout burrows.					
Inspector Comment

Multiple rodent holes observed in the landside slope. (Fall 2023)

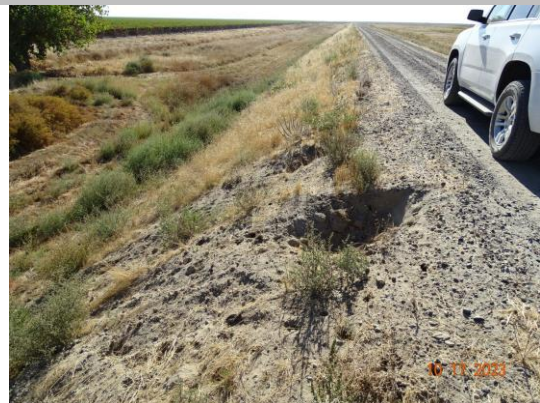
Photo 1 of 1 : FA_2024_NA0010_135_16_20240828_00007.jpg

LM Start	11.10	Rating **	M	Issue No.	16
LM End	11.10	Issue Type +	Ma	Location *	LS
Category	Earthen Levee			GPS Latitude/Longitude	
				Start	End
Item	Erosion / Vehicle Traffic			36.836100 °	36.836100 °
				-120.304535 °	-120.304535 °
DWR ID	DWR_NA0010_17_s_2024_16				
Comment Code					
E6 : Repair the levee slope damaged by vehicle traffic and prevent access where possible.					
Inspector Comment

Vehicle damage to the landside slope and shoulder. (Fall 2023)

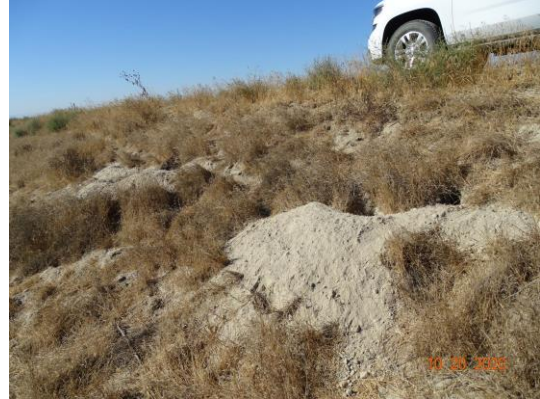
Photo 1 of 1 : FA_2024_NA0010_135_19_20240828_00010.jpg

LM Start	12.25	Rating **	U	Issue No.	19
LM End	12.25	Issue Type +	Ma	Location *	LS
Category	Earthen Levee			GPS Latitude/Longitude	
				Start	End
Item	Animal Control			36.821776°	36.821776°
				-120.300137°	-120.300137°
DWR ID	DWR_NA0010_17_f_2022_19				
Comment Code					
A3 : No rodents visible, but rodent burrows visible; need to backfill and compact or grout burrows.					
Inspector Comment

View of rodent burrows on the landside slope. (Fall 2020)

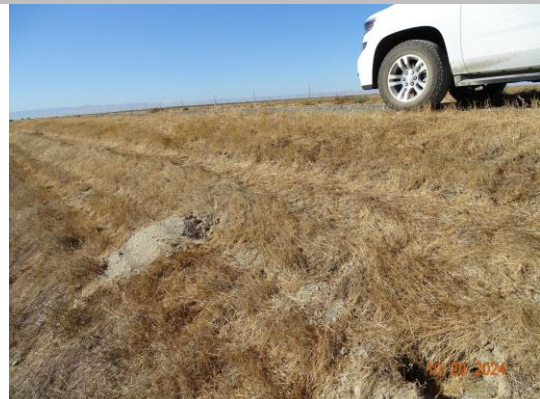
Photo 1 of 1 : FA_2024_NA0010_135_14_20241106_00025.jpg

LM Start	12.41	Rating **	M	Issue No.	14
LM End	12.41	Issue Type +	Ma	Location *	LS
Category	Earthen Levee			GPS Latitude/Longitude	
				Start	End
Item	Animal Control			36.819527 °	36.819527 °
				-120.301031 °	-120.301031 °
DWR ID	DWR_NA0010_17_f_2024_14				
Comment Code					
A3 : No rodents visible, but rodent burrows visible; need to backfill and compact or grout burrows.					
Inspector Comment

View of animal burrows on the landside slope. (Fall 2024)

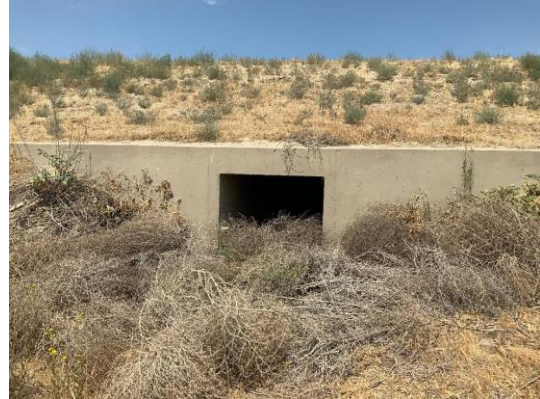
Photo 1 of 2 : UCIP_FA_2024_73440_102440.jpg

DS_ID:19918
FS_ID:73440
EP_NO: N/A
Repair Type: Non-Urgent
EVAL Issue: 11, Maintenance Compliance Issue
Crossing Status: Found
UCIP Comments: 07/13/2021 The record remains Non-Urgent. WS flapgate has plank holding it shut, remove before flood season. Limited inspection due to dense tumbleweeds covering LS pipe inlet, recommend removal. No permit was found authorizing this encroachment. CVFPB will need to review crossing to determine owner. The UCIP inspection was completed with GEI staff, P. Espinoza. (H. Dunn ? GEI)04/01/2014 Some vegetation buildup at inlet-- recommend clearing. (W. Wylie - DWR UCIP)
FIELD_STRUCT_DESC: 48-inch by 60-inch reinforced concrete box gravity drainage culvert (RCBC) through the levee, 15.3 feet below the crown. Flap gate on the waterside (WS) end. Concrete headwall on the landside (LS) end. Concrete U-shaped headwall on the WS end.
[Additional Reference(s): DWR Levee Log, 2002, (HLM 13.29). USACE San Joaquin O&M Manual, Unit No. 601, Part No. 1, 1967, Amended in 1978, Revised 20 June 1985, (HLM 13.30). DWR As-Built Specification No. 64-42, Sheet No. 21, 13 August 1964, (HLM 13.30)].

LS view: Headwall and slope from toe.

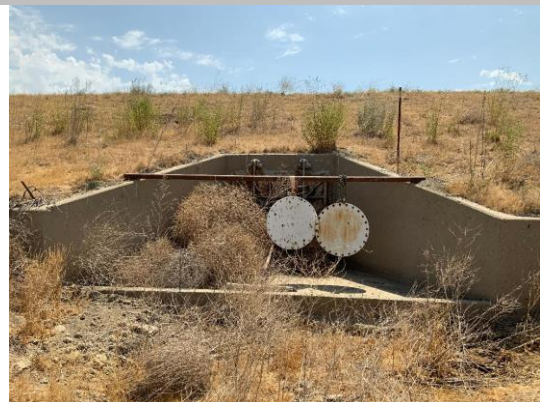
Photo 2 of 2 : UCIP_FA_2024_73440_102437.jpg

WS view: Headwall, flapgate, and slope from toe.

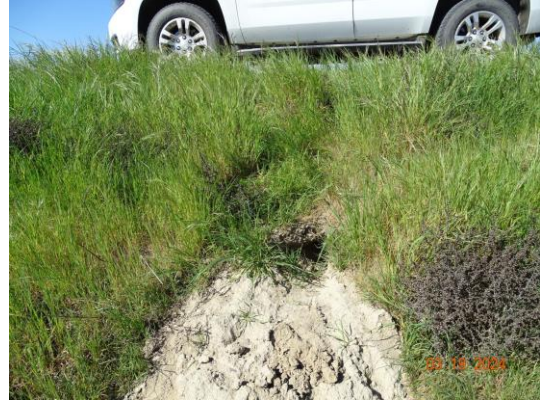
Photo 1 of 1 : FA_2024_NA0010_135_12_20240828_00005.jpg

LM Start	13.64	Rating **	M	Issue No.	12
LM End	13.64	Issue Type +	Ma	Location *	LS
Category	Earthen Levee			GPS Latitude/Longitude	
				Start	End
Item	Animal Control			36.802650 °	36.802650 °
				-120.306999 °	-120.306999 °
DWR ID	DWR_NA0010_17_s _ 2024_12				
Comment Code					
A3 : No rodents visible, but rodent burrows visible; need to backfill and compact or grout burrows.					
Inspector Comment

Representative view of rodent holes on the landside slope. (Spring 2024)

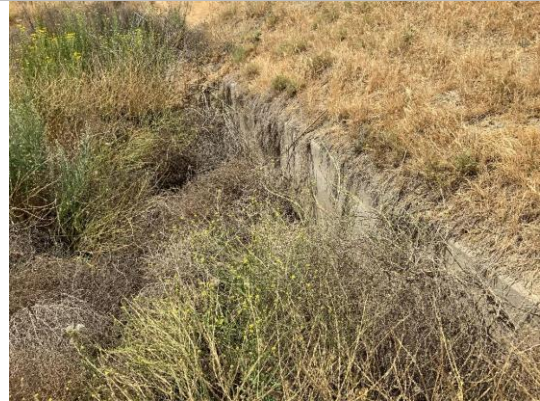
Photo 1 of 2 : UCIP_FA_2024_85075_102476.jpg

Comment Code						
Inspector Comment						
DS_ID:19920 FS_ID:85075 EP_NO: N/A Repair Type: Non-Urgent EVAL Issue: 5, Pipe Damage Crossing Status: Found UCIP Comments: 10/21/2024 Record updated from Urgent to Non-Urgent. Latest PACP inspection did not find SRC (reinforcement corroded) due to panning of camera. (O. Yakimov - DWR UCIP) 12/14/2022 Record updated from Non-Urgent to Urgent. DMP internal video inspection has found pipe integrity issues. LOF of crossing is between 5 and 6. Crossing will be monitored until funding becomes available to address the issues. (O.Yakimov - DWR UCIP) 07/19/2021 The record remains Non-Urgent. Dense tumbleweeds over WS flapgate and LS inlet, recommend removal of both sides. Limited inspection on both WS and LS ends. No permit was found authorizing this encroachment. CVFPB will need to review crossing to determine owner. The UCIP inspection was completed with GEI staff, P. Espinoza. (H. Dunn ? GEI)04/01/2014 Heavy vegetation buildup at LS toe-- recommend clearing. (W. Wylie - DWR UCIP) FIELD_STRUCT_DESC: 30-inch by 30-inch square reinforced concrete box gravity drainage culvert (RCBC) through the levee, 14.0 feet below the crown. Flap gate on the waterside (WS) end. Concrete headwall on the landside (LS) end. Concrete U-shaped headwall on the WS end. [Additional Reference(s): DWR Levee Log, 2002, (HLM 14.70). USACE San Joaquin O&M Manual, Unit No. 601, Part No. 1, 1967, Amended in 1978, Revised 20 June 1985, (HLM 14.69). DWR As-Built Specification No. 64-42, Sheet No. 22, 13 August 1964, (HLM 14.69)]. FS Date: 7/19/2021 2:07:23 PM

LS view: Headwall barely visible at toe due to dense vegetation.

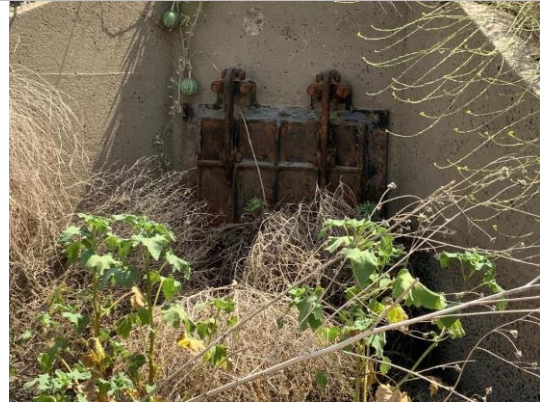
Photo 2 of 2 : UCIP_FA_2024_85075_102473.jpg

WS view: Closeup of flapgate at toe.

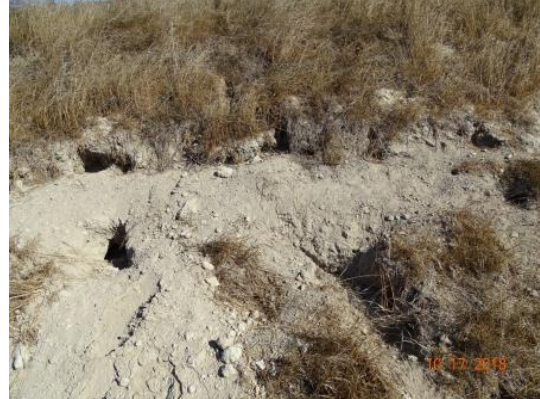
Photo 1 of 1 : FA_2024_NA0010_137_55_20240828_00015.jpg

LM Start	0.78	Rating **	M	Issue No.	55
LM End	0.78	Issue Type +	Ma	Location *	LS
Category	Earthen Levee			GPS Latitude/Longitude	
				Start	End
Item	Animal Control			36.964824 °	36.964824 °
				-120.358065 °	-120.358065 °
DWR ID	DWR_NA0010_18_f _ 2018_55				
Comment Code					
A3 : No rodents visible, but rodent burrows visible; need to backfill and compact or grout burrows.					
Inspector Comment

View of rodent holes from levee toe looking towards centerline. (Fall 2018)
