Flood Control Project Maintenance Levee Inspections

Fall 2024 Levee Maintenance Deficiency Summary Report

San Joaquin River Basin

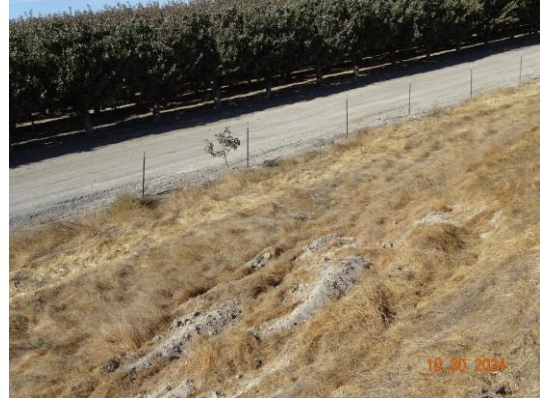
Photo 1 of 1 : FA_2024_NA0010_137_42_20241106_00020.jpg

LM Start	0.86	Rating **	U	Issue No.	42
LM End	0.86	Issue Type +	Ma	Location *	LS
Category	Earthen Levee			GPS Latitude/Longitude	
				Start	End
Item	Erosion / Vehicle Traffic			36.963661 °	36.963661 °
				-120.358210 °	-120.358210 °
DWR ID	DWR_NA0010_18_f_2024_42				
Comment Code					
E6 : Repair the levee slope damaged by vehicle traffic and prevent access where possible.					
Inspector Comment

View of rodent burrows on the landside slope. (Fall 2024)

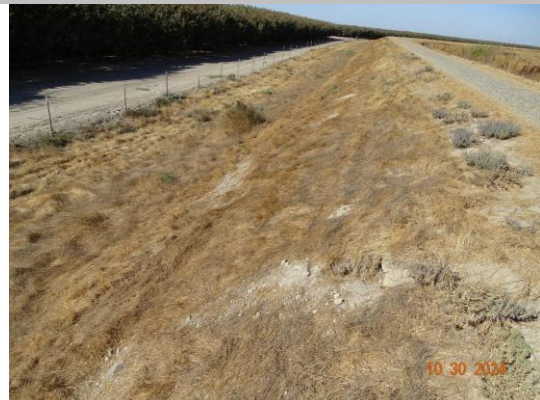
Photo 1 of 1 : FA_2024_NA0010_137_41_20241106_00022.jpg

LM Start	0.99	Rating **		Issue No.	41
LM End	0.99	Issue Type +	--	Location *	LS
Category	Earthen Levee			GPS Latitude/Longitude	
				Start	End
Item	Animal Control			36.961879 °	36.961879 °
				-120.357251 °	-120.357251 °
DWR ID	DWR_NA0010_18_f_2024_41				
Comment Code					
A3 : No rodents visible, but rodent burrows visible; need to backfill and compact or grout burrows.					
Inspector Comment

View of rodent burrows on the landside slope. (Fall 2024)

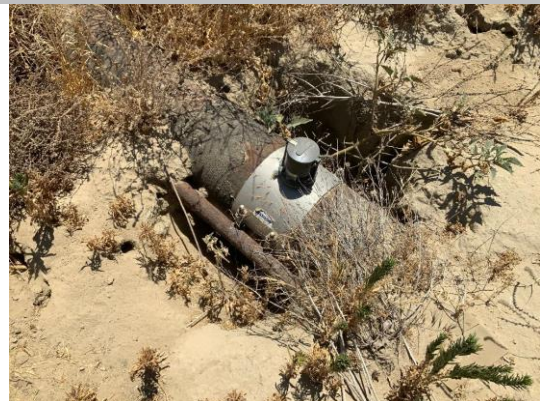
Photo 1 of 1 : UCIP_FA_2024_73459_102065.jpg

Comment Code					
Inspector Comment					
DS_ID:19925 FS_ID:73459 EP_NO: 6603 Repair Type: Non-Urgent EVAL Issue: 6, Levee Damage or Threat for Levee Damage Crossing Status: Found UCIP Comments: 07/20/2021 The record remains Non-Urgent. Flowmeter and pump on pipe appears newer, likely not abandoned as stated in previous inspection. Some erosion around the flowmeter on WS slope. The UCIP inspection was completed with GEI staff, P. Espinoza. (H. Dunn ? GEI)04/10/2014 Need to contact owner. Appears abandoned--good candidate for video or pressure inspection. This crossings is the same age as the pipe that has failed immediately upstream. (DWR UCIP - O. Magana) FIELD_STRUCT_DESC: 15-inch steel irrigation discharge pipe through the levee, 4.3 feet below the crown. Electrical conduit of an unknown size or material through the levee, 4.3 feet below the crown. Siphon breaker on the landside (LS) shoulder. 36-inch concrete standpipe on the LS berm. Inlet facility on the waterside (WS) bank, consisting of a pump, a 42-inch concrete standpipe, and a 20-inch concrete channel with an intake pipe and a cutoff wall. (Outlet pipe and pump authorized under Permit No. 6603, 1969 - Raymond N. Costales). [Additional Reference(s): DWR Levee Log, 2002, (HLM 1.69)]. FS Date: 7/20/2021

WS view: Some erosion around the flowmeter on slope.

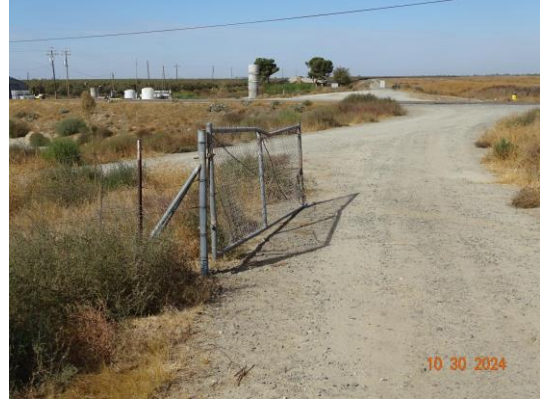
Photo 1 of 1 : FA_2024_NA0010_137_37_20241106_00023.jpg

LM Start	1.73	Rating **	M	Issue No.	37
LM End	1.73	Issue Type +	Ma	Location *	CR
Category	Earthen Levee			GPS Latitude/Longitude	
				Start	End
Item	Access Gates			36.952263 °	36.952263 °
				-120.351304 °	-120.351304 °
DWR ID	DWR_NA0010_18_f_2024_37				
Comment Code					
AG : Access Gates					
Inspector Comment					
Bottom hinge of gate has broken off. Gate should be repaired or replaced.

Bottom hinge of gate has broken off and should be repaired. (Fall 2024)

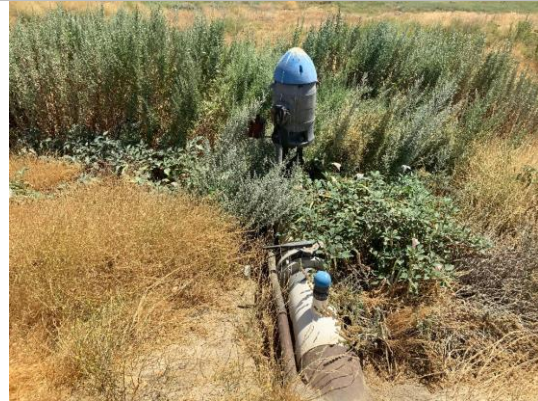
Photo 1 of 1 : UCIP_FA_2024_73463_102080.jpg

Comment Code					
Inspector Comment					
DS_ID:19926 FS_ID:73463 EP_NO: 6603 Repair Type: Non-Urgent EVAL Issue: 11, Maintenance Compliance Issue Crossing Status: Found UCIP Comments: 07/20/2021 The record remains Non-Urgent. WS has some vegetation growth around the pump and pipe on the slope, recommend removal. No LS standpipe or siphon breaker visible and new filtration system set up landward off the LS toe. Unsure if pipe connected to filtration system and penetrating the ground on LS belongs to this crossing. Confirm with owner on the status of this pipe and the alignment. The UCIP inspection was completed with GEI staff, P. Espinoza. (H. Dunn ? GEI)7/20/2016 High burrow activity. Dense vegetation limits the inspector's visibility to identify signs of pipe failure (leaks) along the WS and LS slope. Recommend removing vegetation along pipe alignment to conduct proper inspection of structure and appurtenances. (DWR UCIP - omagana)10/2014 Subsidence present along pipe alignment on landward side. Modified crossing--worked done on landward side. Need to contact owner to determine permit authorizing work. Dense vegetation on landward side--tall grass. Pipe wall cut and new pipe sleeved on landward side. (DWR UCIP - omagana) FIELD_STRUCT_DESC: 15-inch steel irrigation discharge pipe and electrical conduit through the levee, 3.7 feet below the crown. Siphon breaker on the landside (LS) shoulder. 36-inch concrete standpipe on the LS berm. Inlet facility on the riverbank, consisting of a pump, a 42-inch concrete standpipe, and a 20-inch concrete channel with an intake pipe and a cutoff wall. (Outlet pipe and pump authorized under Permit No. 6603, 1969 - Raymond N. Costales). [Additional Reference(s): DWR Levee Log, 2002, (HLM 2.25)]. FS Date: 7/20/2021

WS view: Pump and pipe off slope, covered with vegetation.

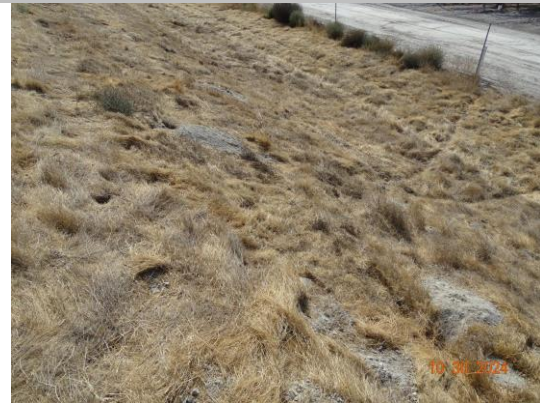
Photo 1 of 1 : FA_2024_NA0010_137_34_20241106_00024.jpg

LM Start	2.83	Rating **	M	Issue No.	34
LM End	2.96	Issue Type +	Ma	Location *	LS
Category	Earthen Levee			GPS Latitude/Longitude	
				Start	End
Item	Animal Control			36.937585 °	36.935789 °
				-120.344070 °	-120.343407 °
DWR ID	DWR_NA0010_18_f_2024_34				
Comment Code					
A3 : No rodents visible, but rodent burrows visible; need to backfill and compact or grout burrows.					
Inspector Comment

View of rodent burrows on the landside slope. (Fall 2024)

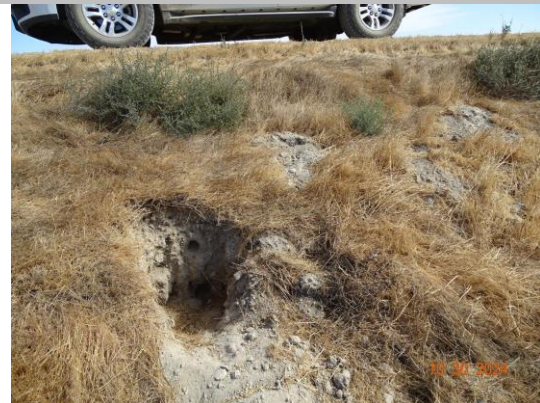
Photo 1 of 1 : FA_2024_NA0010_137_30_20241106_00025.jpg

LM Start	3.07	Rating **	U	Issue No.	30
LM End	3.07	Issue Type +	Ma	Location *	LS
Category	Earthen Levee			GPS Latitude/Longitude	
				Start	End
Item	Animal Control			36.934211 °	36.934211 °
				-120.342834 °	-120.342834 °
DWR ID	DWR_NA0010_18_f_2024_30				
Comment Code					
A3 : No rodents visible, but rodent burrows visible; need to backfill and compact or grout burrows.					
Inspector Comment

View of rodent burrows on the landside slope. (Fall 2024)

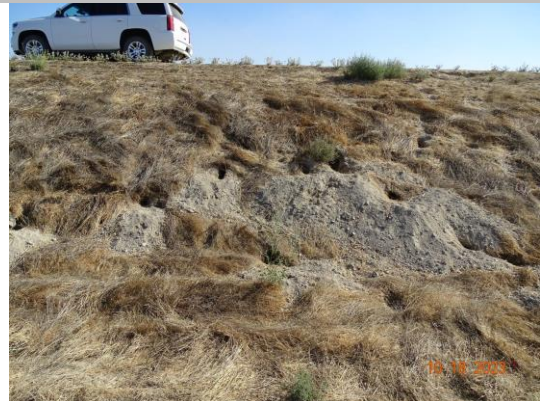
Photo 1 of 1 : FA_2024_NA0010_137_32_20240828_00010.jpg

LM Start	3.34	Rating **	M	Issue No.	32
LM End	3.34	Issue Type +	Ma	Location *	LS
Category	Earthen Levee			GPS Latitude/Longitude	
				Start	End
Item	Animal Control			36.930419 °	36.930419 °
				-120.341433 °	-120.341433 °
DWR ID	DWR_NA0010_18_f_2023_32				
Comment Code					
A3 : No rodents visible, but rodent burrows visible; need to backfill and compact or grout burrows.					
Inspector Comment

View of rodent holes on the landside slope. (Fall 2023)

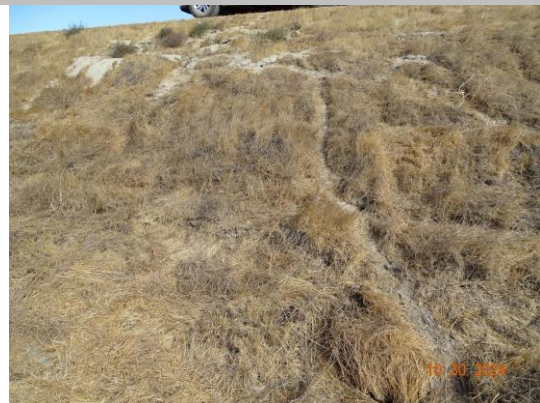
Photo 1 of 1 : FA_2024_NA0010_137_31_20241106_00026.jpg

LM Start	3.41	Rating **	U	Issue No.	31
LM End	3.44	Issue Type +	Ma	Location *	LS
Category	Earthen Levee			GPS Latitude/Longitude	
				Start	End
Item	Animal Control			36.929498 °	36.929093 °
				-120.341091 °	-120.340920 °
DWR ID	DWR_NA0010_18_f_2019_31				
Comment Code					
A3 : No rodents visible, but rodent burrows visible; need to backfill and compact or grout burrows.					
Inspector Comment					
Rodent burrows on the landside slope and toe.

View of rodent burrows on the landside slope. (Fall 2024)

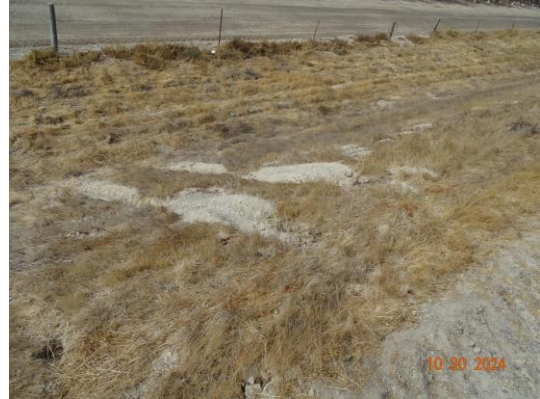
Photo 1 of 1 : FA_2024_NA0010_137_29_20241106_00027.jpg

LM Start	3.63	Rating **	M	Issue No.	29
LM End	3.63	Issue Type +	Ma	Location *	LS
Category	Earthen Levee			GPS Latitude/Longitude	
				Start	End
Item	Erosion / Vehicle Traffic			36.926479 °	36.926479 °
				-120.339996 °	-120.339996 °
DWR ID	DWR_NA0010_18_f_2024_29				
Comment Code					
E6 : Repair the levee slope damaged by vehicle traffic and prevent access where possible.					
Inspector Comment

Looking at vehicle damage to the landside slope. (Fall 2024)

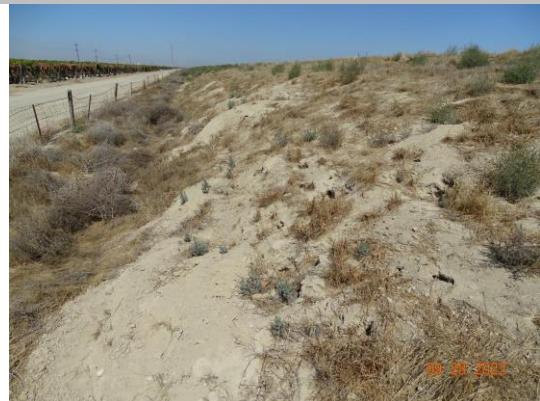
Photo 1 of 1 : FA_2024_NA0010_137_44_20240828_00013.jpg

LM Start	3.93	Rating **	U	Issue No.	44
LM End	3.98	Issue Type +	Ma	Location *	LS
Category	Earthen Levee			GPS Latitude/Longitude	
				Start	End
Item	Animal Control			36.922195 °	36.921549 °
				-120.338412 °	-120.338173 °
DWR ID	DWR_NA0010_18_f_2022_44				
Comment Code					
A3 : No rodents visible, but rodent burrows visible; need to backfill and compact or grout burrows.					
Inspector Comment					
Several rodent burrows observed in the landside slope and berm.

Several rodent holes noted in this section. (Fall 2022)

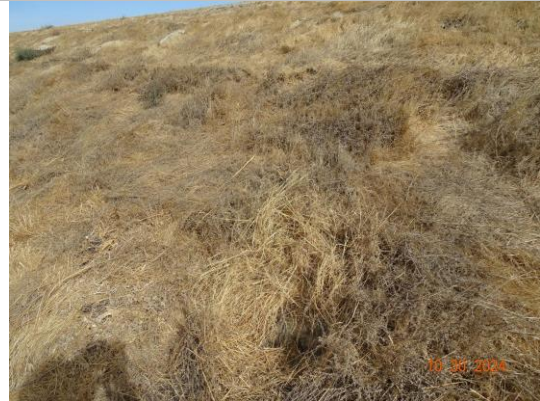
Photo 1 of 1 : FA_2024_NA0010_137_20_20241106_00028.jpg

LM Start	4.33	Rating **	M	Issue No.	20
LM End	4.38	Issue Type +	Ma	Location *	LS
Category	Earthen Levee			GPS Latitude/Longitude	
				Start	End
Item	Animal Control			36.916685 °	36.916061 °
				-120.336388 °	-120.336164 °
DWR ID	DWR_NA0010_18_s_2021_20				
Comment Code					
A3 : No rodents visible, but rodent burrows visible; need to backfill and compact or grout burrows.					
Inspector Comment

View of rodent burrows on the landside slope. (Fall 2024)

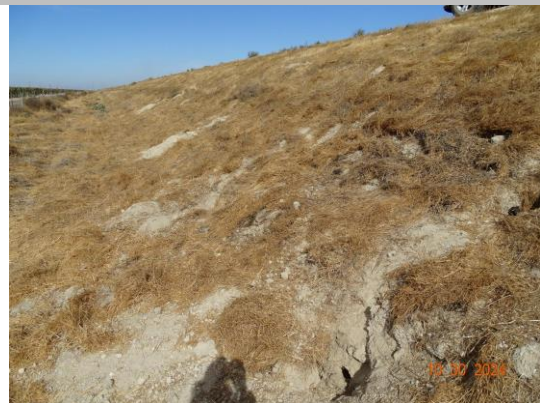
Photo 1 of 1 : FA_2024_NA0010_137_28_20241106_00029.jpg

LM Start	4.43	Rating **	M	Issue No.	28
LM End	4.43	Issue Type +	Ma	Location *	LS
Category	Earthen Levee			GPS Latitude/Longitude	
				Start	End
Item	Animal Control			36.915300 °	36.915300 °
				-120.335906 °	-120.335906 °
DWR ID	DWR_NA0010_18_f_2024_28				
Comment Code					
A1 : Exterminate rodents and backfill and compact or grout burrows.					
Inspector Comment

View of rodent burrows on the landside slope. (Fall 2024)

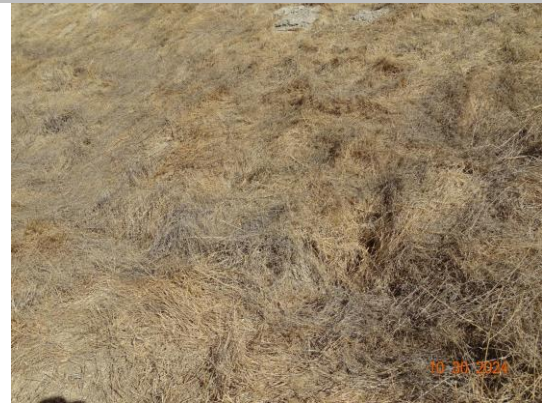
Photo 1 of 1 : FA_2024_NA0010_137_19_20241106_00030.jpg

LM Start	4.80	Rating **	M	Issue No.	19
LM End	4.80	Issue Type +	Ma	Location *	LS
Category	Earthen Levee			GPS Latitude/Longitude	
				Start	End
Item	Animal Control			36.910130 °	36.910130 °
				-120.334002 °	-120.334002 °
DWR ID	DWR_NA0010_18_f_2020_19				
Comment Code					
A3 : No rodents visible, but rodent burrows visible; need to backfill and compact or grout burrows.					
Inspector Comment					
Large rodent burrow at the landside toe.

View of rodent burrows on the landside slope. (Fall 2024)

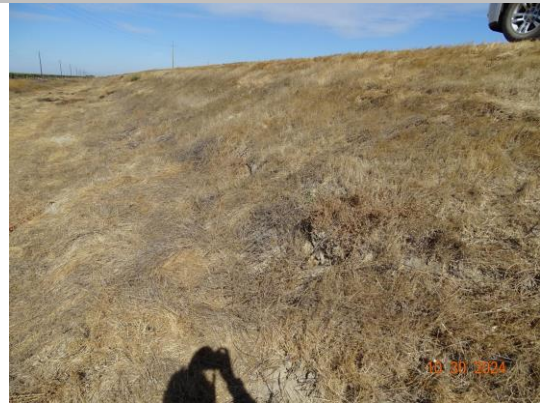
Photo 1 of 1 : FA_2024_NA0010_137_15_20241106_00031.jpg

LM Start	5.74	Rating **	U	Issue No.	15
LM End	5.99	Issue Type +	Ma	Location *	LS
Category	Earthen Levee			GPS Latitude/Longitude	
				Start	End
Item	Animal Control			36.897237 °	36.893924 °
				-120.328633 °	-120.327020 °
DWR ID	DWR_NA0010_18_f _ 2017_15				
Comment Code					
A3 : No rodents visible, but rodent burrows visible; need to backfill and compact or grout burrows.					
Inspector Comment					
There are multiple large rodent holes at the landside toe.

View of rodent burrows on the landside slope. (Fall 2024)

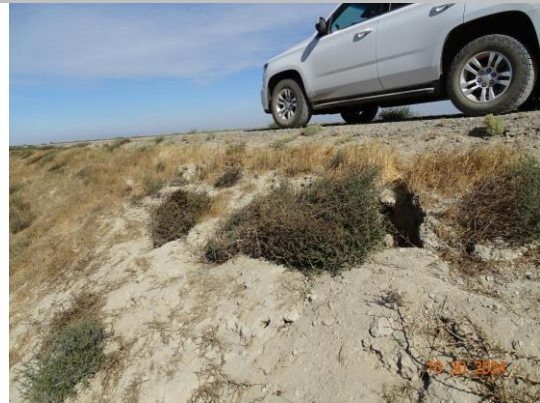
Photo 1 of 1 : FA_2024_NA0010_137_39_20241106_00032.jpg

LM Start	6.29	Rating **	M	Issue No.	39
LM End	6.47	Issue Type +	Ma	Location *	LS
Category	Earthen Levee			GPS Latitude/Longitude	
				Start	End
Item	Animal Control			36.889791 °	36.887446 °
				-120.324977 °	-120.323832 °
DWR ID	DWR_NA0010_18_f_2022_39				
Comment Code					
A3 : No rodents visible, but rodent burrows visible; need to backfill and compact or grout burrows.					
Inspector Comment					
Several rodent burrows observed along the slope and toe.

View of rodent burrows on the landside slope. (Fall 2024)

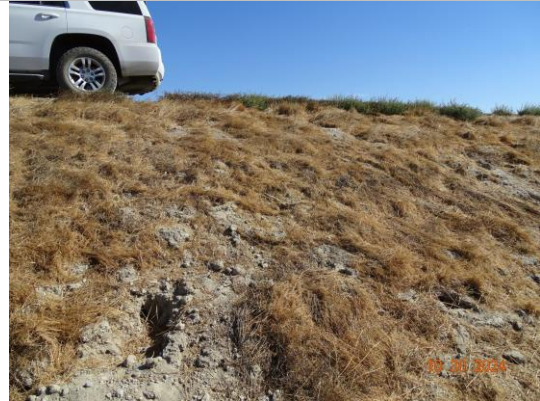
Photo 1 of 1 : FA_2024_NA0010_137_26_20241106_00033.jpg

LM Start	6.53	Rating **	M	Issue No.	26
LM End	6.53	Issue Type +	Ma	Location *	LS
Category	Earthen Levee			GPS Latitude/Longitude	
				Start	End
Item	Animal Control			36.886612 °	36.886612 °
				-120.323453 °	-120.323453 °
DWR ID	DWR_NA0010_18_f _ 2024_26				
Comment Code					
A3 : No rodents visible, but rodent burrows visible; need to backfill and compact or grout burrows.					
Inspector Comment

View of rodent burrows on the landside slope. (Fall 2024)

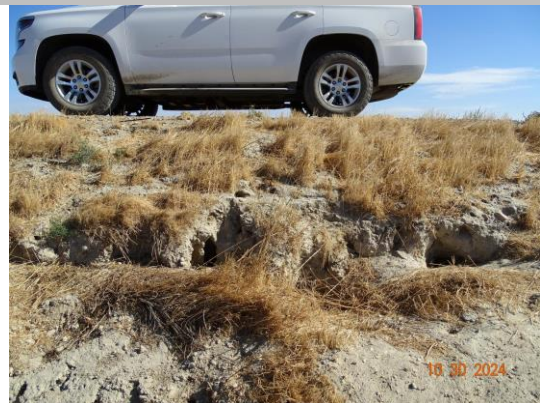
Photo 1 of 1 : FA_2024_NA0010_137_38_20241106_00034.jpg

LM Start	6.62	Rating **	U	Issue No.	38
LM End	6.67	Issue Type +	Ma	Location *	LS
Category	Earthen Levee			GPS Latitude/Longitude	
				Start	End
Item	Animal Control			36.885376 °	36.884648 °
				-120.322820 °	-120.322466 °
DWR ID	DWR_NA0010_18_f_2022_38				
Comment Code					
A3 : No rodents visible, but rodent burrows visible; need to backfill and compact or grout burrows.					
Inspector Comment

Representative view of multiple rodent holes in the sections. (Fall 2024)

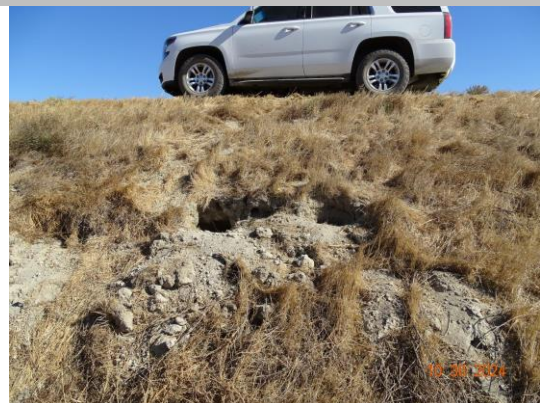
Photo 1 of 1 : FA_2024_NA0010_137_24_20241106_00035.jpg

LM Start	6.71	Rating **	U	Issue No.	24
LM End	6.71	Issue Type +	Ma	Location *	LS
Category	Earthen Levee			GPS Latitude/Longitude	
				Start	End
Item	Animal Control			36.884135°	36.884135°
				-120.322251°	-120.322251°
DWR ID	DWR_NA0010_18_f_2024_24				
Comment Code					
A3 : No rodents visible, but rodent burrows visible; need to backfill and compact or grout burrows.					
Inspector Comment

View of large rodent holes in the landside slope. (Fall 2024)

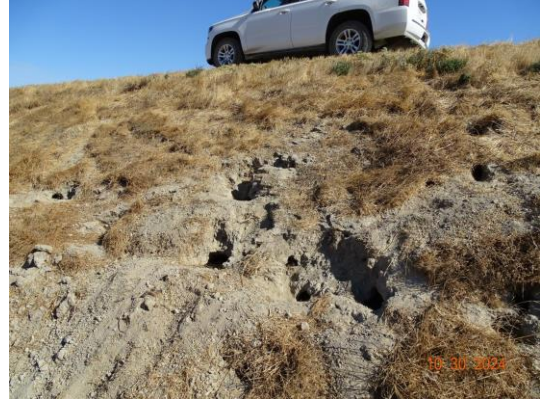
Photo 1 of 1 : FA_2024_NA0010_137_23_20241106_00036.jpg

LM Start	6.82	Rating **	U	Issue No.	23
LM End	6.84	Issue Type +	Ma	Location *	LS
Category	Earthen Levee			GPS Latitude/Longitude	
				Start	End
Item	Animal Control			36.882696 °	36.882384 °
				-120.321574 °	-120.321417 °
DWR ID	DWR_NA0010_18_f _ 2019_23				
Comment Code					
A1 : Exterminate rodents and backfill and compact or grout burrows.					
Inspector Comment

Representative rodent burrows observed along this section. (Fall 2024)

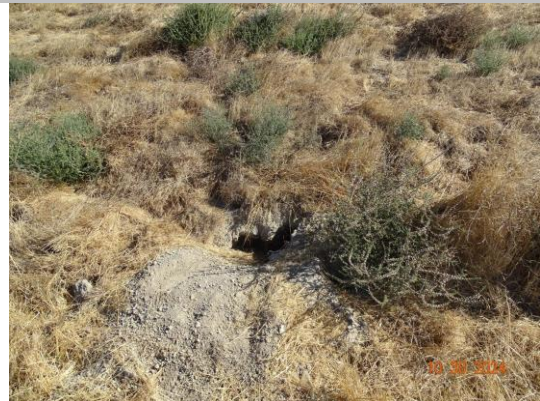
Photo 1 of 1 : FA_2024_NA0010_137_22_20241106_00037.jpg

LM Start	6.87	Rating **	M	Issue No.	22
LM End	6.91	Issue Type +	Ma	Location *	LS
Category	Earthen Levee			GPS Latitude/Longitude	
				Start	End
Item	Animal Control			36.881961 °	36.881369 °
				-120.321310 °	-120.321188 °
DWR ID	DWR_NA0010_18_f_2024_22				
Comment Code					
A3 : No rodents visible, but rodent burrows visible; need to backfill and compact or grout burrows.					
Inspector Comment

Representative rodent burrow noted in this section. (Fall 2024)

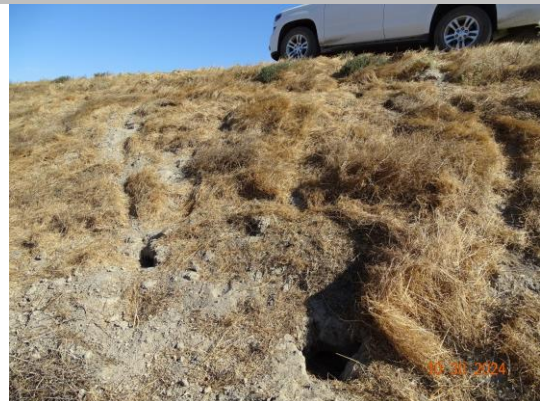
Photo 1 of 1 : FA_2024_NA0010_137_17_20241106_00038.jpg

LM Start	6.97	Rating **	M	Issue No.	17
LM End	6.97	Issue Type +	Ma	Location *	LS
Category	Earthen Levee			GPS Latitude/Longitude	
				Start	End
Item	Animal Control			36.880475 °	36.880475 °
				-120.321012 °	-120.321012 °
DWR ID	DWR_NA0010_18_f_2024_17				
Comment Code					
A3 : No rodents visible, but rodent burrows visible; need to backfill and compact or grout burrows.					
Inspector Comment

View of rodent burrows on the landside slope. (Fall 2024)

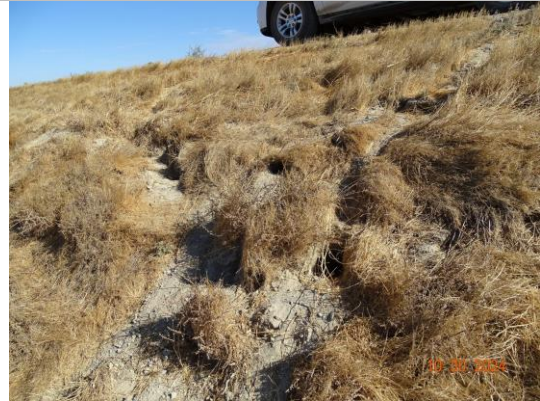
Photo 1 of 1 : FA_2024_NA0010_137_12_20241106_00039.jpg

LM Start	7.03	Rating **	M	Issue No.	12
LM End	7.03	Issue Type +	Ma	Location *	LS
Category	Earthen Levee			GPS Latitude/Longitude	
				Start	End
Item	Animal Control			36.879613 °	36.879613 °
				-120.320845 °	-120.320845 °
DWR ID	DWR_NA0010_18_f_2024_12				
Comment Code					
A3 : No rodents visible, but rodent burrows visible; need to backfill and compact or grout burrows.					
Inspector Comment

View of rodent burrows on the landside slope. (Fall 2024)

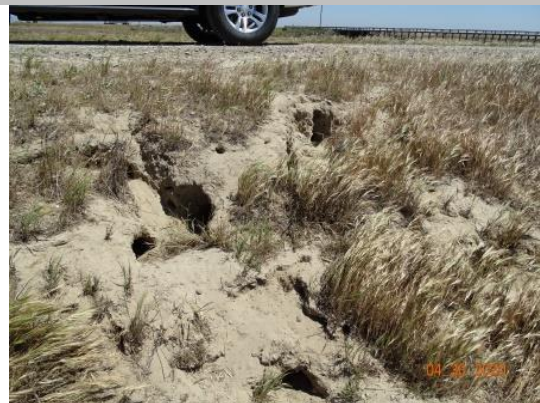
Photo 1 of 1 : FA_2024_NA0010_137_14_20240828_00004.jpg

LM Start	7.39	Rating **	U	Issue No.	14
LM End	7.53	Issue Type +	Ma	Location *	LS
Category	Earthen Levee			GPS Latitude/Longitude	
				Start	End
Item	Animal Control			36.874479 °	36.872503 °
				-120.319831 °	-120.319438 °
DWR ID	DWR_NA0010_18_f_2017_14				
Comment Code					
A3 : No rodents visible, but rodent burrows visible; need to backfill and compact or grout burrows.					
Inspector Comment					
There are several rodent holes noted along the landside slope in this area.

View of rodent burrows in the landside slope. (Spring 2020)

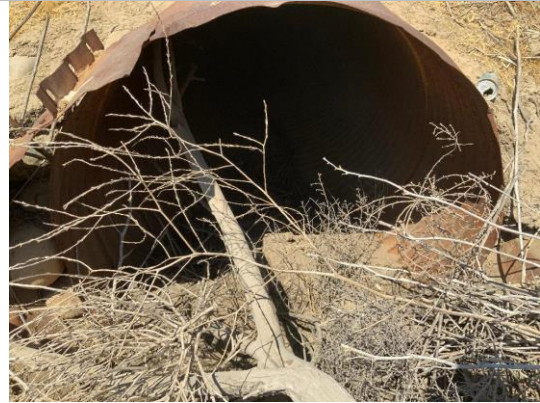
Photo 1 of 1 : UCIP_FA_2024_73468_102096.jpg

Comment Code					
Inspector Comment					
DS_ID:19930 FS_ID:73468 EP_NO: 13548 Repair Type: Non-Urgent EVAL Issue: 11, Maintenance Compliance Issue Crossing Status: Found UCIP Comments: 07/20/2021 The record remains Non-Urgent. No longer debris or sediment inside LS pipe outlet. WS pipe does not appear to be distorted, but has minor vegetation over inlet, recommend removal. The UCIP inspection was completed with GEI staff, P. Espinoza. (H. Dunn ? GEI)04/10/2014 CMP crossing is distorted on waterward side. Debris scattered on landward side. Sediment deposit inside crossing visible from landward side. Recommend removing debris from landward side. (DWR UCIP - O. Magana) FIELD_STRUCT_DESC: 42-inch reinforced concrete (RC) gravity irrigation pipe through the levee, 19.0 feet below the crown. Gate structure on the waterside (WS) shoulder. Pipe section on the WS is made of corrugated metal (CM). Pipe section on the landside (LS) is made of RC. (42-inch RC gravity irrigation pipe authorized under Permit No. 13548, 1983 - New Stone Water District). [Additional Reference(s): DWR Levee Log, 2002, (HLM 7.53)]. FS Date: 7/30/2021 3:01:27 PM

WS view: Closeup of pipe inlet at toe.

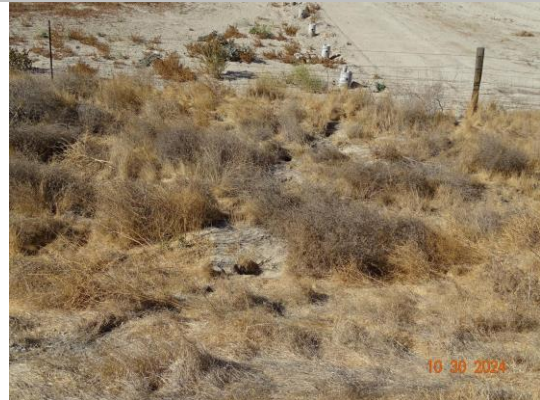
Photo 1 of 1 : FA_2024_NA0010_137_11_20241106_00040.jpg

LM Start	7.66	Rating **	U	Issue No.	11
LM End	7.66	Issue Type +	Ma	Location *	LS
Category	Earthen Levee			GPS Latitude/Longitude	
				Start	End
Item	Animal Control			36.870638 °	36.870638 °
				-120.319107 °	-120.319107 °
DWR ID	DWR_NA0010_18_f_2024_11				
Comment Code					
A3 : No rodents visible, but rodent burrows visible; need to backfill and compact or grout burrows.					
Inspector Comment					
Several large rodent holes on the landside toe.

Several rodent burrows observed in the landside slope. (Fall 2024)

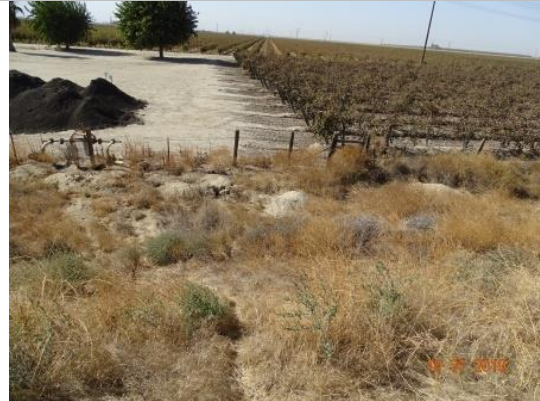
Photo 1 of 1 : FA_2024_NA0010_137_21_20240828_00007.jpg

LM Start	7.91	Rating **	U	Issue No.	21
LM End	7.98	Issue Type +	Ma	Location *	LS
Category	Earthen Levee			GPS Latitude/Longitude	
				Start	End
Item	Animal Control			36.867030 °	36.866092 °
				-120.318361 °	-120.318180 °
DWR ID	DWR_NA0010_18_f _ 2019_21				
Comment Code					
A3 : No rodents visible, but rodent burrows visible; need to backfill and compact or grout burrows.					
Inspector Comment					
Several large rodent burrows in the landside toe.

Several rodent burrows observed at the landside toe. (Fall 2019)

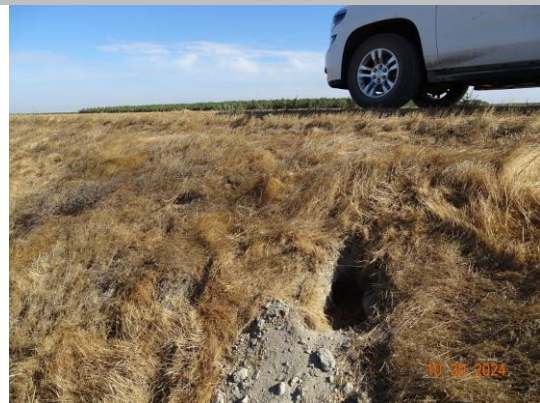
Photo 1 of 1 : FA_2024_NA0010_137_10_20241106_00041.jpg

LM Start	8.62	Rating **	M	Issue No.	10
LM End	8.62	Issue Type +	Ma	Location *	LS
Category	Earthen Levee			GPS Latitude/Longitude	
				Start	End
Item	Animal Control			36.856864 °	36.856864 °
				-120.316641 °	-120.316641 °
DWR ID	DWR_NA0010_18_f_2024_10				
Comment Code					
A3 : No rodents visible, but rodent burrows visible; need to backfill and compact or grout burrows.					
Inspector Comment

View of rodent burrows on the landside slope. (Fall 2024)

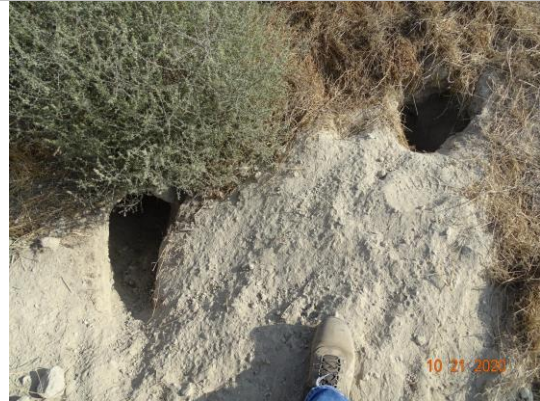
Photo 1 of 1 : FA_2024_NA0010_137_18_20240828_00006.jpg

LM Start	8.89	Rating **	U	Issue No.	18
LM End	8.89	Issue Type +	Ma	Location *	LS
Category	Earthen Levee			GPS Latitude/Longitude	
				Start	End
Item	Animal Control			36.852936 °	36.852936 °
				-120.316451 °	-120.316451 °
DWR ID	DWR_NA0010_18_f_2020_18				
Comment Code					
A3 : No rodents visible, but rodent burrows visible; need to backfill and compact or grout burrows.					
Inspector Comment

Large rodent holes in the landside slope. (Fall 2020)

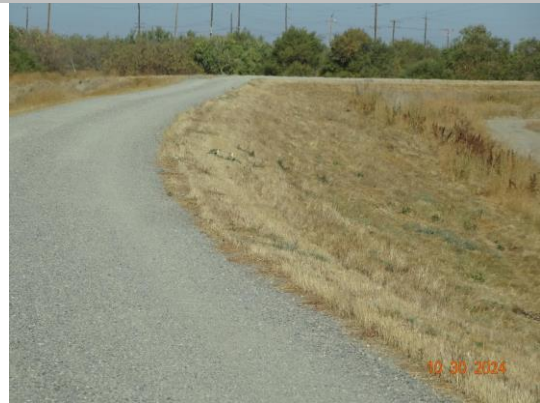
Photo 1 of 1 : FA_2024_NA0010_137_6_20241106_00042.jpg

LM Start	14.15	Rating **	A	Issue No.	6
LM End	14.15	Issue Type +	Ma	Location *	WS
Category	Earthen Levee			GPS Latitude/Longitude	
				Start	End
Item	Vegetation			36.785380 °	36.785380 °
				-120.300386 °	-120.300386 °
DWR ID	DWR_NA0010_18_f_2024_6				
Comment Code					
V1 : Control annual grass and weeds on the levee slopes and easements.					
Inspector Comment

View of vegetation management on the waterside slope. (Fall 2024)

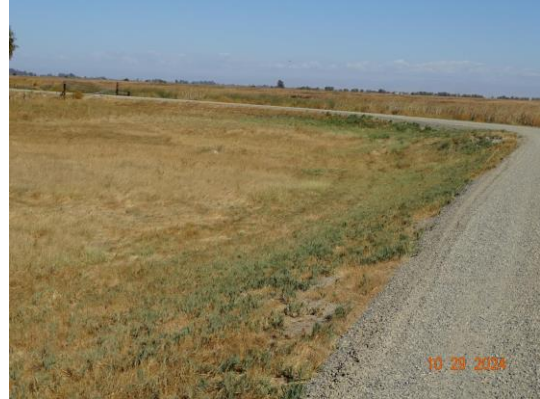
Photo 1 of 1 : FA_2024_NA0010_138_13_20241106_00030.jpg

LM Start	0.03	Rating **	A	Issue No.	13
LM End	0.03	Issue Type +	Ma	Location *	LS
Category	Earthen Levee			GPS Latitude/Longitude	
				Start	End
Item	Vegetation			37.206166 °	37.206166 °
				-120.696658 °	-120.696658 °
DWR ID	DWR_NA0010_22A_f_2024_13				
Comment Code					
V1 : Control annual grass and weeds on the levee slopes and easements.					
Inspector Comment

View of vegetation management on the landside slope. (Fall 2024)

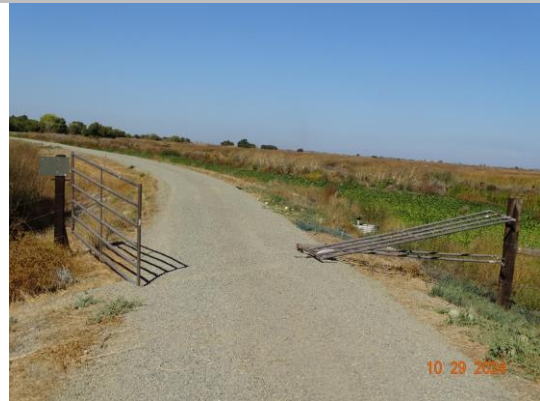
Photo 1 of 1 : FA_2024_NA0010_138_16_20241106_00031.jpg

LM Start	0.09	Rating **	M	Issue No.	16
LM End	0.09	Issue Type +	Ma	Location *	CR
Category	Earthen Levee			GPS Latitude/Longitude	
				Start	End
Item	Access Gates			37.206890 °	37.206890 °
				-120.696281 °	-120.696281 °
DWR ID	DWR_NA0010_22A_f_2024_16				
Comment Code					
AG : Access Gates					
Inspector Comment

Access gate has broken hinges and should be repaired or replaced. (Fall 2024)

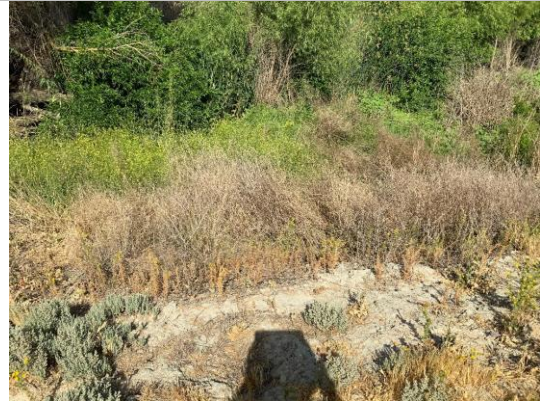
Photo 1 of 2 : UCIP_FA_2024_73507_103856.jpg

Comment Code						
Inspector Comment						
DS_ID:19933 FS_ID:73507 EP_NO: N/A Repair Type: Non-Urgent EVAL Issue: 4b, Safety Issue Crossing Status: Found UCIP Comments: 06/09/2021 The record remains Non-Urgent. Limited inspection of LS due to dense vegetation; recommend removal. Limited inspection on WS due to elevated water level. No pipe inlet or outlet was visible on LS or WS. Riser on WS missing lid, causing a safety hazard. No permit was found authorizing this encroachment. CVFPB will need to review crossing to determine owner. The UCIP inspection was completed with GEI staff, H.Dunn. (P.Espinoza ? GEI)						
07/19/2016 Gate inside riser appears operable--riser lid damage. Crossing is not visible on LS due to dense vegetation. Recommend clearing dense vegetation along WS and LS slope and repairing riser cover. (O. Magana - DWR UCIP) 04/15/2014 No actuator wheel on slide gate at WS shoulder. (W. Wylie - DWR UCIP) FIELD_STRUCT_DESC: 24-inch corrugated metal gravity drainage pipe (CMP) through the levee, 14.8 feet below the crown. Slide gate in a 36-inch CMP riser unit on the waterside (WS) slope. Concrete U-shaped headwall on each end. [Additional Reference(s): DWR Levee Log, 2002, (HLM 0.10). USACE San Joaquin O&M Manual, Unit No. 601, Part No. 1, 1967, Amended in 1978, Revised 20 June 1985, (HLM 0.10). DWR As-Built Specification No. 63-25, Sheet No. 15, 9 May 1963, (HLM 0.10)]. FS Date: 6/9/2021 12:38:00 PM

LS view: Toe from crown, dense vegetation.

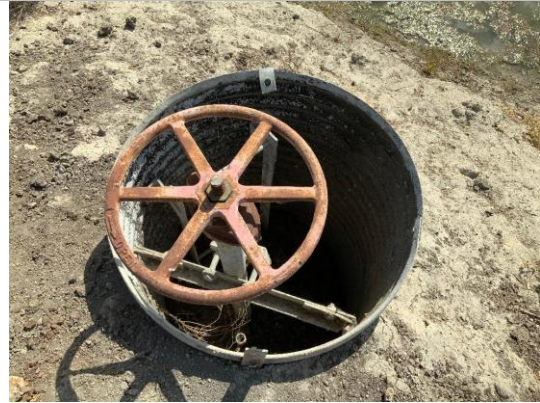
Photo 2 of 2 : UCIP_FA_2024_73507_103855.jpg

LM Start	0.10	Rating **	M	Issue No.	38 (cont)
LM End	0.10	Issue Type +	Ma	Location *	
Category	Supplemental			GPS Latitude/Longitude	
				Start	End
Item	DWR UCIP LMA Responsibility			37.207039 °	37.207039 °
				-120.696255 °	-120.696255 °
DWR ID	19933

WS view: close up of CMP riser on slope.

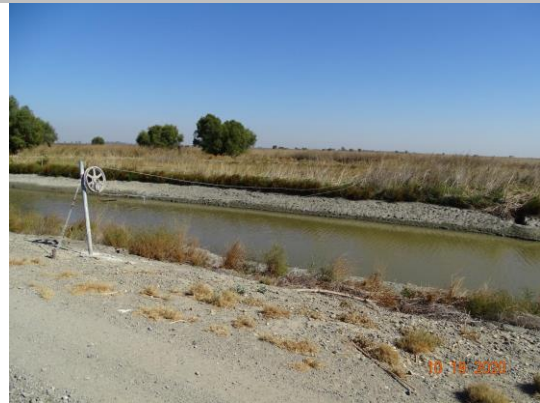
Photo 1 of 1 : FA_2024_NA0010_138_23_20240828_00013.jpg

LM Start	0.87	Rating **	M	Issue No.	23
LM End	0.87	Issue Type +	En	Location *	WS
Category	Earthen Levee			GPS Latitude/Longitude	
				Start	End
Item	Encroachments			37.217802 °	37.217802 °
				-120.697416 °	-120.697416 °
DWR ID	DWR_NA0010_22A_f_2014_23				
Comment Code					
SI : Sign					
Inspector Comment					
A pulley is located on the waterside shoulder without a board permit.

Pulley on the waterside shoulder. (Fall 2020)

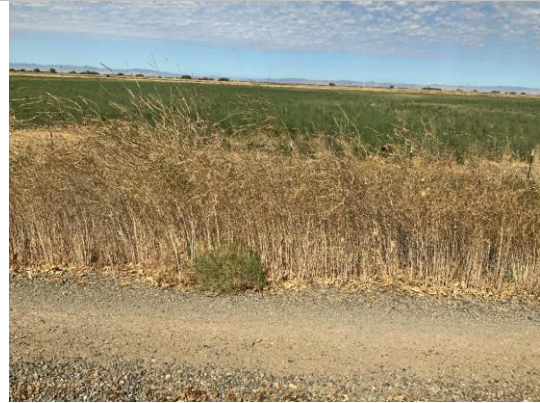
Photo 1 of 2 : UCIP_FA_2024_77873_103906.jpg

Comment Code						
Inspector Comment						
DS_ID:19936 FS_ID:77873 EP_NO: N/A Repair Type: Urgent EVAL Issue: 1, Pipe Integrity Crossing Status: Found UCIP Comments: 12/14/2022 Record updated from Non-Urgent to Urgent. DMP internal video inspection has found pipe integrity issues. LOF of crossing is between 5 and 6. Crossing will be monitored until funding becomes available to address the issues. (O.Yakimov - DWR UCIP) 06/09/2021 The record remains Non-Urgent. Appears abandoned due to headwall not being found on LS. (CMP) riser has no lid, causing a safety hazard; debris visible inside riser, recommend clearing out unless confirmed abandoned. Limited inspection on WS due to water and on LS due to dense vegetation, recommend removal of LS vegetation. No permit was found authorizing this encroachment. CVFPB will need to review crossing to determine owner. The UCIP inspection was completed with GEI staff, H.Dunn. (P.Espinoza ? GEI) 04/15/2014 Slide gate rusted and does not function. Headwall buried at LS toe. Pipe appears abandoned and if so should be done so properly. (W. Wylie - DWR UCIP) FIELD_STRUCT_DESC: 8-inch corrugated metal gravity irrigation pipe (CMP) through the levee, 7.0 feet below the crown. Slide gate in a 36-inch CMP riser unit on the waterside (WS) slope. Concrete headwall on the landside (LS) end. [Additional Reference(s): DWR Levee Log, 2002, (HLM 1.57). USACE San Joaquin O&M Manual, Unit No. 601, Part No. 1, 1967, Amended in 1978, Revised 20 June 1985, (HLM 1.57). DWR As-Built Specification No. 63-25, Sheet No. 16, 9 May 1963, (HLM 1.57)]. FS Date: 6/9/2021 2:09:50 PM

LS view: Toe from crown, dense vegetation.

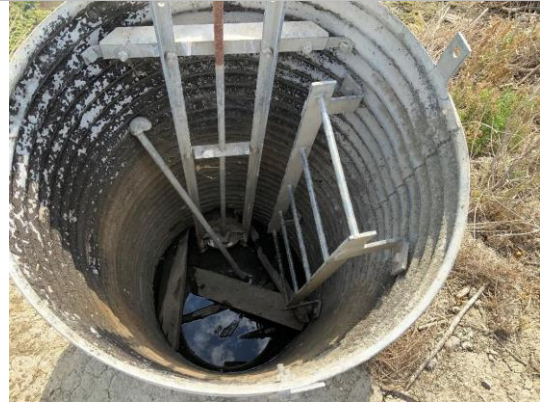
Photo 2 of 2 : UCIP_FA_2024_77873_103903.jpg

LM Start	1.57	Rating **	U	Issue No.	39 (cont)
LM End	1.57	Issue Type +	En	Location *	
Category	Supplemental			GPS Latitude/Longitude	
				Start	End
Item	DWR UCIP Field Study			37.227588 °	37.227588 °
				-120.700945 °	-120.700945 °
DWR ID	19936

WS view: closeup of interior of (CMP) riser.

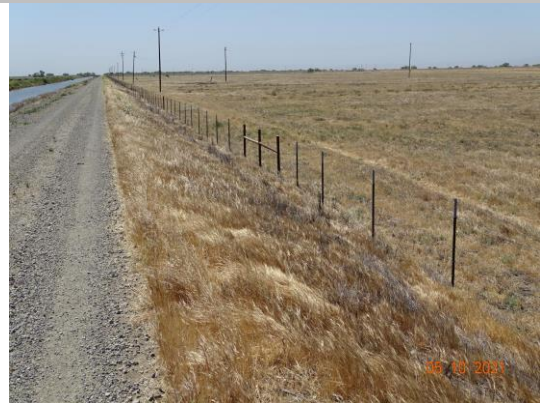
Photo 1 of 1 : FA_2024_NA0010_138_28_20240828_00015.jpg

LM Start	1.75	Rating **	A/W	Issue No.	28
LM End	2.60	Issue Type +	En	Location *	LS
Category	Earthen Levee			GPS Latitude/Longitude	
				Start	End
Item	Encroachments			37.230585 °	37.242371 °
				-120.702045 °	-120.706371 °
DWR ID	DWR_NA0010_22A_f_2018_28				
Comment Code					
FE : Fence					
Inspector Comment					
A fence is located along the landside toe. This is shown in the as-built drawings.

View of fence along landside toe. (Spring 2021)

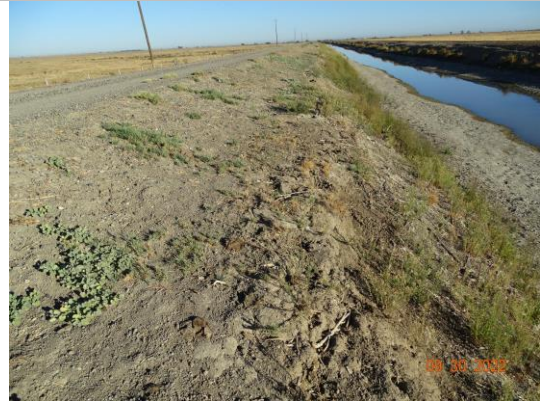
Photo 1 of 1 : FA_2024_NA0010_138_29_20240828_00016.jpg

LM Start	2.25	Rating **	M	Issue No.	29
LM End	2.37	Issue Type +	Ma	Location *	WS
Category	Earthen Levee			GPS Latitude/Longitude	
				Start	End
Item	Erosion / Livestock			37.237050 °	37.238776 °
				-120.704393 °	-120.705028 °
DWR ID	DWR_NA0010_22A_f_2018_29				
Comment Code					
E4 : Repair the levee slope damaged by livestock and prevent large animal access.					
Inspector Comment					
There is slope erosion from livestock, the slope is no longer 3:1.

View of damage to the waterside slope looking downstream. (Fall 2022)

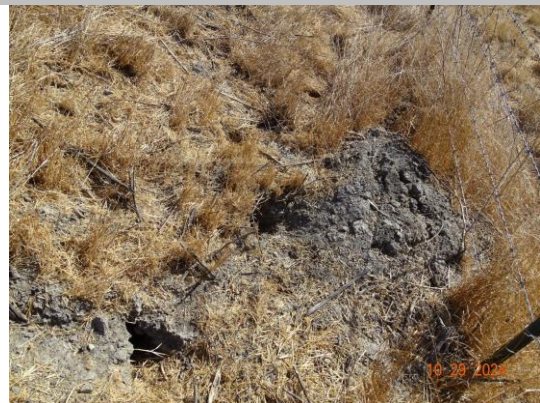
Photo 1 of 1 : FA_2024_NA0010_138_18_20241106_00032.jpg

LM Start	2.60	Rating **	M	Issue No.	18
LM End	2.60	Issue Type +	Ma	Location *	LS
Category	Earthen Levee			GPS Latitude/Longitude	
				Start	End
Item	Animal Control			37.241978 °	37.241978 °
				-120.706216 °	-120.706216 °
DWR ID	DWR_NA0010_22A_f_2024_18				
Comment Code					
A3 : No rodents visible, but rodent burrows visible; need to backfill and compact or grout burrows.					
Inspector Comment					
Rodent burrows observed along the fence line.

View of rodent burrows on the landside slope. (Fall 2024)

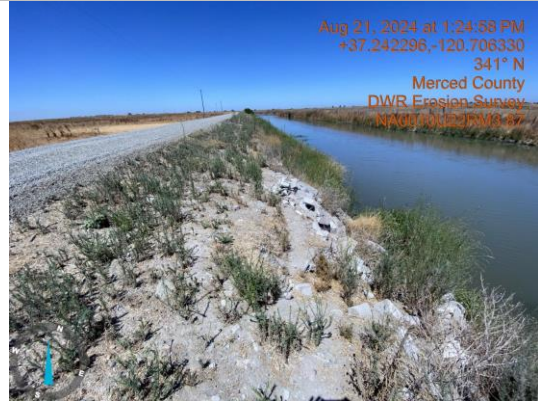
Photo 1 of 1 : SJR2024_NA0010U22RM3.87_3.JPG

LM Start	2.65	Rating **	U	Issue No.	1	
LM End	2.66	Issue Type +	Ma	Location *	WS	
Category	Supplemental			GPS Latitude/Longitude		
				Start	End	
Item	DWR Erosion Survey			37.242595 °	37.242595 °	
				-120.706470 °	-120.706470 °	
DWR ID	NA0010U22RM3.87					
Comment Code						
Inspector Comment						
Site ID: NA0010U22RM3.87						
8/21/2024: From 2020 to present, no significant changes were observed during the annual survey.						
08/18/2020: The site has been covered with loose fill and crushed concrete pieces. The erosion will likely worsen again during the next high water.						
09/12/2019: The erosion has cut into the levee prism and damaged almost half of the levee. The livestock traffic has likely caused the erosion.

8/21/2024: View of the erosion with fill and concrete looking downstream.

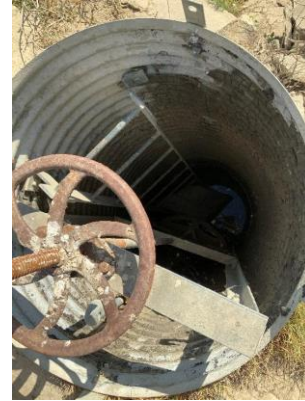
Photo 1 of 1 : UCIP_FA_2024_73518_103912.jpg

Item	DWR UCIP Field Study			37.243501 °	37.243501 °					
				-120.706773 °	-120.706773 °					
DWR ID	19937									
Comment Code										
Inspector Comment										
DS_ID:19937 FS_ID:73518 EP_NO: N/A Repair Type: Non-Urgent EVAL Issue: 4b, Safety Issue Crossing Status: Found UCIP Comments: 06/09/2021 The record remains Non-Urgent. Appears abandoned due to no found headwall on LS toe. (CMP) riser missing lid, causing a safety hazard. Slidegate appears to be open; visible water in CMP riser. Limited inspection of WS inlet due to it being underwater at the time of survey. No permit was found authorizing this encroachment. CVFPB will need to review crossing to determine owner. The UCIP inspection was completed with GEI staff, H.Dunn. (P.Espinoza ? GEI) 04/15/2014 Slide gate does not function and should be repaired. Headwall at LS toe not found. (W. Wylie - DWR UCIP) FIELD_STRUCT_DESC: 24-inch corrugated metal irrigation siphon pipe (CMP) through the levee, 7.5 feet below the crown. Slide gate in a 36-inch CMP riser unit on the waterside (WS) slope. Concrete U-shaped headwall on the landside (LS) end. [Additional Reference(s): DWR Levee Log, 2002, (HLM 2.72). USACE San Joaquin O&M Manual, Unit No. 601, Part No. 1, 1967, Amended in 1978, Revised 20 June 1985, (HLM 2.72). DWR As-Built Specification No. 63-25, Sheet No. 17, 9 May 1963, (HLM 2.72)]. FS Date: 6/9/2021 3:03:00 PM

WS view: Water visible in riser on slope.

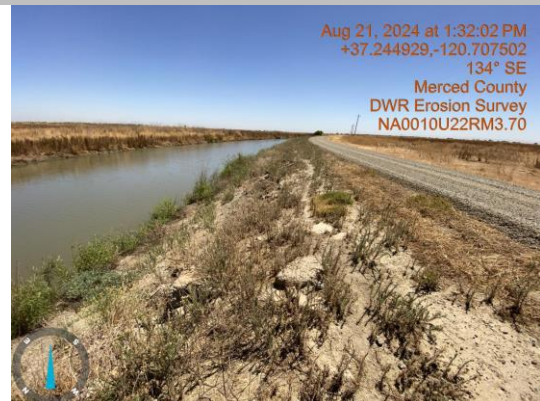
Photo 1 of 1 : SJR2024_NA0010U22RM3.70_1.JPG

LM Start	2.82	Rating **	U	Issue No.	2					
LM End	2.83	Issue Type +	Ma	Location *	WS					
Category	Supplemental			GPS Latitude/Longitude						
				Start	End					
Item	DWR Erosion Survey			37.244940 °	37.244940 °					
				-120.707467 °	-120.707467 °					
DWR ID	NA0010U22RM3.7									
Comment Code										
Inspector Comment										
Site ID: NA0010U22RM3.7 8/21/2024: From 2019 to present, no significant changes were observed during the annual survey. In some areas, the levee shoulder width is up to 8 ft. There is some crushed concrete on the levee slope. 09/12/2019: The erosion has damaged entire levee slope. The livestock traffic likely has caused the erosion.

8/21/2024: View of the erosion looking downstream.

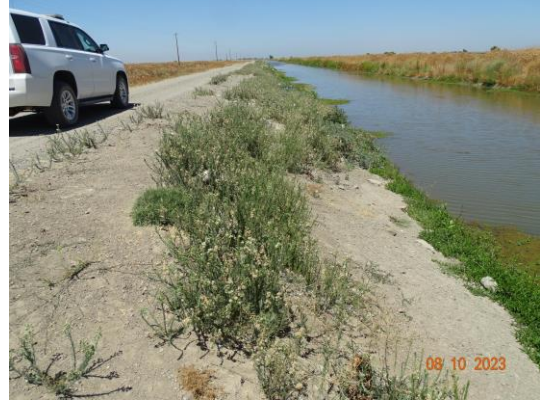
Photo 1 of 1 : FA_2024_NA0010_138_26_20240828_00014.jpg

LM Start	2.87	Rating **	A/W	Issue No.	26
LM End	2.87	Issue Type +	Ma	Location *	WS
Category	Earthen Levee			GPS Latitude/Longitude	
				Start	End
Item	Erosion / Bank Caving			37.245536 °	37.245536 °
				-120.708119 °	-120.708119 °
DWR ID	DWR_NA0010_22A_f _ 2023_26				
Comment Code					
E1 : Note and monitor erosion site.					
Inspector Comment					
Site ID: NA0010U22RM3.65 10/30/23: Issue transferred from Erosion Survey and will continue to be monitored. 08/03/2022: From 2021 to present, no significant changes were observed during the annual survey. 08/18/2020: No vegetation visible in the area of the erosion. Noticed some crushed concrete pieces on the levee slope and a small amount of loose fill. 09/12/2019: The erosion has damaged entire levee slope. The livestock traffic likely has caused the erosion.

View of erosion on the waterside slope. (Fall 2023)

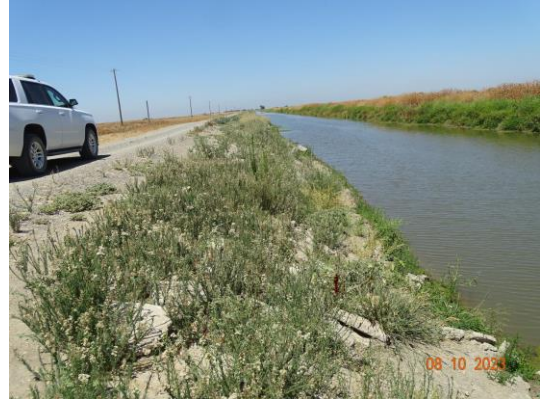
Photo 1 of 1 : FA_2024_NA0010_138_4_20240828_00004.jpg

LM Start	2.96	Rating **	A/W	Issue No.	4
LM End	2.96	Issue Type +	Ma	Location *	WS
Category	Earthen Levee			GPS Latitude/Longitude	
				Start	End
Item	Erosion / Bank Caving			37.246408 °	37.246408 °
				-120.709197 °	-120.709197 °
DWR ID	DWR_NA0010_22A_f_2023_4				
Comment Code					
E1 : Note and monitor erosion site.					
Inspector Comment					
Site ID: NA0010U22RM3.56 10/30/23: Issue transferred from Erosion Survey and will continue to be monitored. 08/03/2022: From 2021 to present, no significant changes were observed during the annual survey. 08/18/2020: The erosion has been covered with loose fill and crushed concrete pieces. A nearly vertical slope remains at the levee toe in some sections. The site will likely worsen again during the next high water. 09/12/2019: The erosion has damaged entire levee slope. The livestock activity likely has caused the erosion.

View of erosion site on the waterside slope. (Fall 2023)

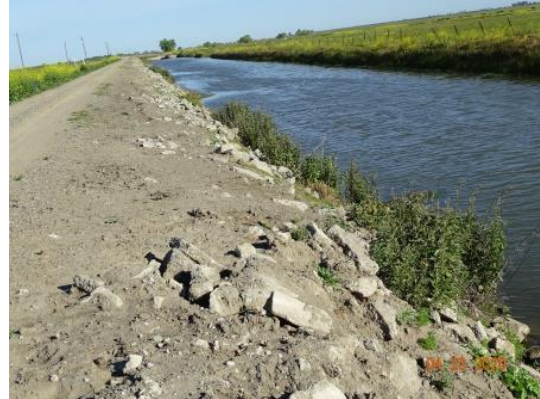
Photo 1 of 1 : FA_2024_NA0010_138_34_20240828_00020.jpg

LM Start	3.44	Rating **	A/W	Issue No.	34
LM End	3.44	Issue Type +	Ma	Location *	WS
Category	Earthen Levee			GPS Latitude/Longitude	
				Start	End
Item	Erosion / Livestock			37.251370 °	37.251370 °
				-120.715344 °	-120.715344 °
DWR ID	DWR_NA0010_22A_f_2018_34				
Comment Code					
E4 : Repair the levee slope damaged by livestock and prevent large animal access.					
Inspector Comment					
Broken concrete was placed on the waterside slope to prevent erosion from livestock.

Fill and concrete were placed to repair erosion on the waterside slope.
Concrete with rebar should be removed. (Spring 2020)

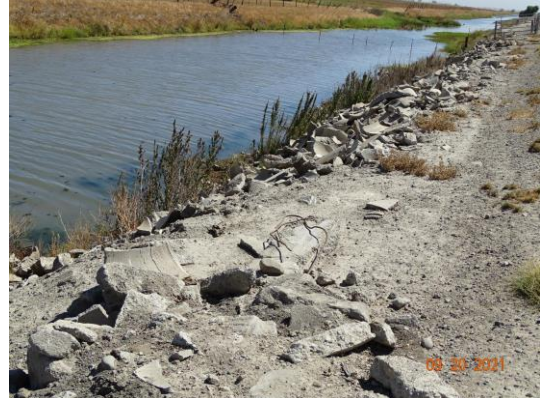
Photo 1 of 1 : FA_2024_NA0010_138_35_20240828_00021.jpg

LM Start	3.47	Rating **	A/W	Issue No.	35
LM End	3.50	Issue Type +	Ma	Location *	WS
Category	Earthen Levee			GPS Latitude/Longitude	
				Start	End
Item	Erosion / Livestock			37.251621 °	37.251978 °
				-120.715649 °	-120.716143 °
DWR ID	DWR_NA0010_22A_f_2018_35				
Comment Code					
E4 : Repair the levee slope damaged by livestock and prevent large animal access.					
Inspector Comment					
Waterside slope erosion is from livestock activity. Slope stabilized with broken concrete.

Fill and concrete placed on the waterside slope. Rebar should be removed for safety. (Fall 2021)

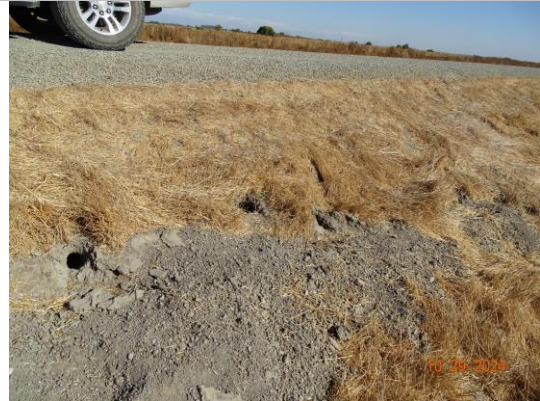
Photo 1 of 1 : FA_2024_NA0010_138_19_20241106_00033.jpg

LM Start	3.57	Rating **	M	Issue No.	19
LM End	3.57	Issue Type +	Ma	Location *	LS
Category	Earthen Levee			GPS Latitude/Longitude	
				Start	End
Item	Animal Control			37.252627 °	37.252627 °
				-120.716954 °	-120.716954 °
DWR ID	DWR_NA0010_22A_f_2024_19				
Comment Code					
A3 : No rodents visible, but rodent burrows visible; need to backfill and compact or grout burrows.					
Inspector Comment

View of rodent burrows on the landside slope. (Fall 2024)

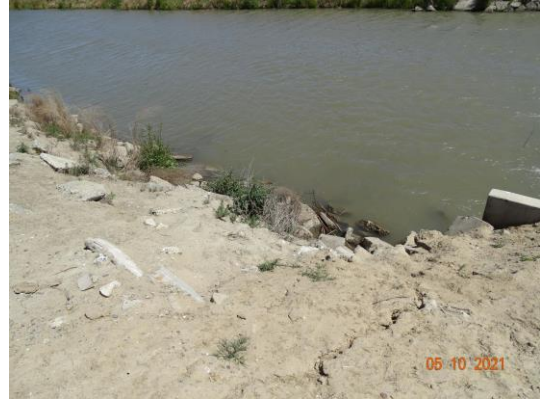
Photo 1 of 1 : FA_2024_NA0010_138_14_20240828_00008.jpg

LM Start	3.82	Rating **	M	Issue No.	14
LM End	3.82	Issue Type +	Ma	Location *	WS
Category	Earthen Levee			GPS Latitude/Longitude	
				Start	End
Item	Erosion / Livestock			37.255239 °	37.255239 °
				-120.720142 °	-120.720142 °
DWR ID	DWR_NA0010_22A_f_ 2017_14				
Comment Code					
E4 : Repair the levee slope damaged by livestock and prevent large animal access.					
Inspector Comment					
Broken concrete previously placed to stabilize the slope has washed out.

Damage to the waterside slope. (Spring 2021)

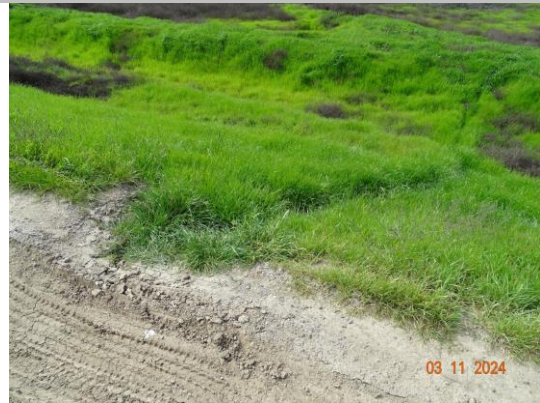
Photo 1 of 1 : FA_2024_NA0010_138_15_20240828_00009.jpg

LM Start	4.11	Rating **	M	Issue No.	15
LM End	4.11	Issue Type +	Ma	Location *	LS
Category	Earthen Levee			GPS Latitude/Longitude	
				Start	End
Item	Erosion / Livestock			37.258353 °	37.258353 °
				-120.723824 °	-120.723824 °
DWR ID	DWR_NA0010_22A_f_ 2019_15				
Comment Code					
E4 : Repair the levee slope damaged by livestock and prevent large animal access.					
Inspector Comment

View of erosion in the landside slope and shoulder from livestock traffic.
(Spring 2024)

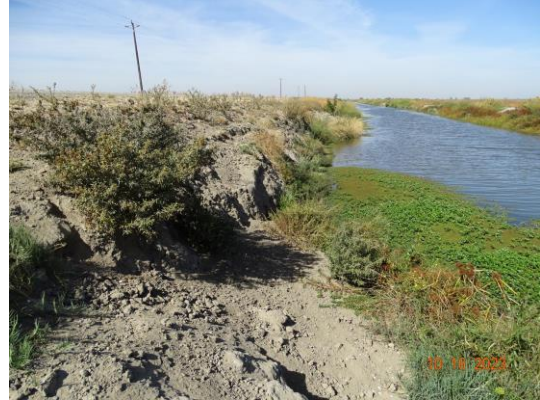
Photo 1 of 1 : FA_2024_NA0010_138_31_20240828_00018.jpg

LM Start	4.21	Rating **	U	Issue No.	31
LM End	4.21	Issue Type +	Ma	Location *	WS
Category	Earthen Levee			GPS Latitude/Longitude	
				Start	End
Item	Erosion / Livestock			37.259370 °	37.259370 °
				-120.725012 °	-120.725012 °
DWR ID	DWR_NA0010_22A_f_2023_31				
Comment Code					
E4 : Repair the levee slope damaged by livestock and prevent large animal access.					
Inspector Comment

View of levee waterside slope erosion looking downstream. (Fall 2023)

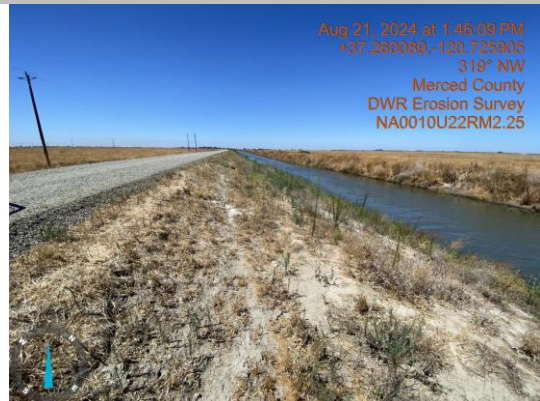
Photo 1 of 1 : SJR2024_NA0010U22RM2.25_3.JPG

LM Start	4.26	Rating **	A/W	Issue No.	3
LM End	4.30	Issue Type +	Ma	Location *	WS
Category	Supplemental			GPS Latitude/Longitude	
				Start	End
Item	DWR Erosion Survey			37.260111 °	37.260111 °
				-120.725900 °	-120.725900 °
DWR ID	NA0010U22RM2.25				
Comment Code					
Inspector Comment					
Site ID: NA0010U22RM2.25					
8/21/2024: Erosion has been repaired.					
8/10/2023: From 2019 to present, no significant changes were observed during the annual survey.					
09/12/2019: Erosion has developed into the lower levee slope. Loose material was observed at the site.

8/21/2024: View of the erosion repair looking downstream.

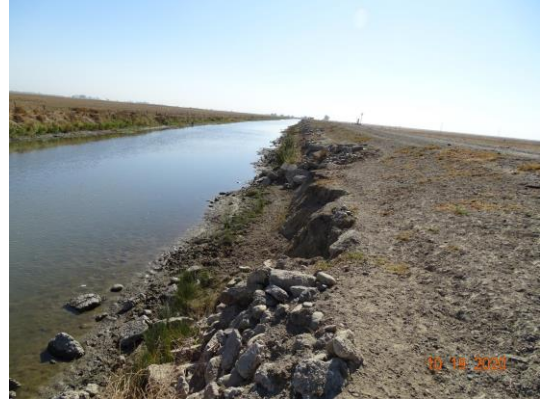
Photo 1 of 1 : FA_2024_NA0010_138_37_20240828_00022.jpg

LM Start	4.30	Rating **	U	Issue No.	37
LM End	5.11	Issue Type +	Ma	Location *	WS
Category	Earthen Levee			GPS Latitude/Longitude	
				Start	End
Item	Erosion / Livestock			37.260111°	37.268135°
				-120.725900°	-120.737130°
DWR ID	DWR_NA0010_22A_f_2018_37				
Comment Code					
E4 : Repair the levee slope damaged by livestock and prevent large animal access.					
Inspector Comment					
Erosion is cutting into the waterside slope. Some sections have been stabilized with cobble stone and broken concrete.

View of waterside slope damage looking upstream. (Fall 2020)

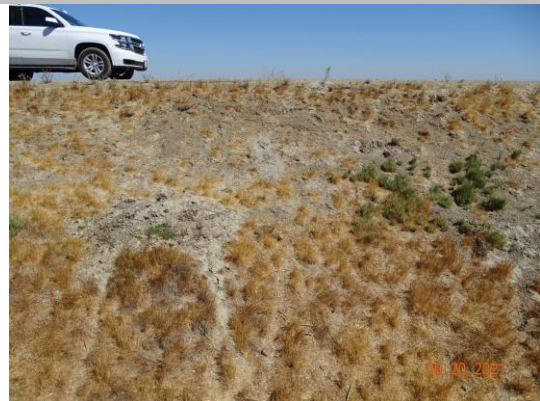
Photo 1 of 1 : FA_2024_NA0010_138_21_20240828_00012.jpg

LM Start	4.42	Rating **	M	Issue No.	21
LM End	4.42	Issue Type +	Ma	Location *	LS
Category	Earthen Levee			GPS Latitude/Longitude	
				Start	End
Item	Animal Control			37.261573 °	37.261573 °
				-120.727622 °	-120.727622 °
DWR ID	DWR_NA0010_22A_f_2021_21				
Comment Code					
A3 : No rodents visible, but rodent burrows visible; need to backfill and compact or grout burrows.					
Inspector Comment					
District has placed a bait station at the location.

View of displaced earth and rodent holes in the landside slope. (Fall 2021)

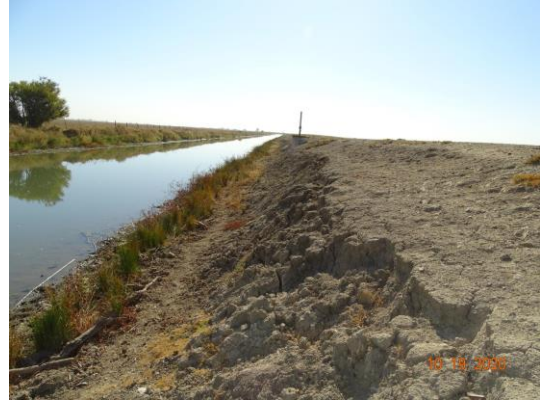
Photo 1 of 1 : FA_2024_NA0010_138_6_20240828_00005.jpg

LM Start	5.12	Rating **	A/W	Issue No.	6
LM End	5.49	Issue Type +	Ma	Location *	WS
Category	Earthen Levee			GPS Latitude/Longitude	
				Start	End
Item	Erosion / Livestock			37.268236 °	37.272262 °
				-120.737210 °	-120.741778 °
DWR ID	DWR_NA0010_22A_s_2022_6				
Comment Code					
E4 : Repair the levee slope damaged by livestock and prevent large animal access.					
Inspector Comment					
Slope damage is caused by livestock on waterside toe.

Looking southeast at livestock erosion on waterward toe. (Fall 2020)
