Flood Control Project Maintenance Levee Inspections

Fall 2024 Levee Maintenance Deficiency Summary Report

San Joaquin River Basin

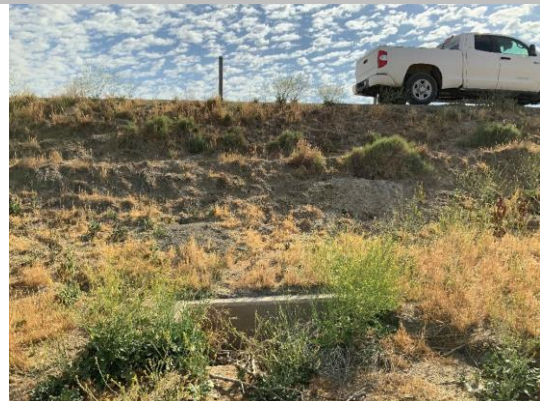
Photo 1 of 2 : UCIP_FA_2024_73519_103919.jpg

Comment Code						
Inspector Comment						
DS_ID:19938 FS_ID:73519 EP_NO: N/A Repair Type: Non-Urgent EVAL Issue: 11, Maintenance Compliance Issue Crossing Status: Found UCIP Comments: 06/09/2021 The record remains Non-Urgent. Appears abandoned due to the LS headwall being buried in sediment and debris buildup, recommend clearing out. Inlet pipe on WS is not visible due to water in channel at the time of the survey. Limited inspection on both WS and LS pipe inlet/outlet. No permit was found authorizing this encroachment. CVFPB will need to review crossing to determine owner. The UCIP inspection was completed with GEI staff, H.Dunn. (P.Espinoza ? GEI)04/15/2014 Need to contact owner. Pipe silted in on LS toe. Appears abandoned and if so should be done so properly. (W. Wylie - DWR UCIP) FIELD_STRUCT_DESC: 48-inch corrugated metal irrigation siphon pipe (CMP) through the levee, 10.0 feet below the crown. Slide gate in a 60-inch CMP riser unit on the waterside (WS) slope. Concrete headwall on the landside (LS) end. WS end capped with a 0.25-inch steel plate. [Additional Reference(s): DWR Levee Log, 2002, (HLM 5.48). USACE San Joaquin O&M Manual, Unit No. 601, Part No. 1, 1967, Amended in 1978, Revised 20 June 1985, (HLM 5.48). DWR As-Built Specification No. 63-25, Sheet No. 19, 9 May 1963, (HLM 5.48)]. FS Date: 6/9/2021 3:14:00 PM

LS view: slope and buried headwall at toe.

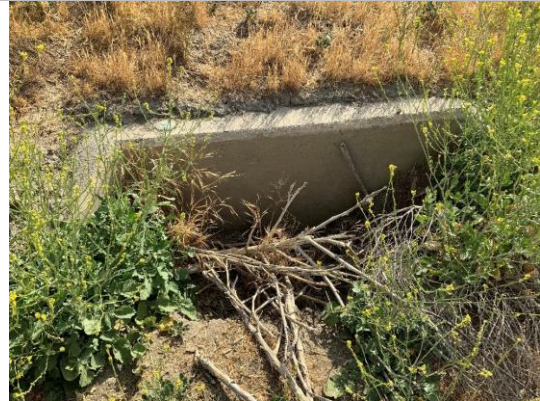
Photo 2 of 2 : UCIP_FA_2024_73519_103920.jpg

LS view: Closeup of buried concrete headwall at toe.

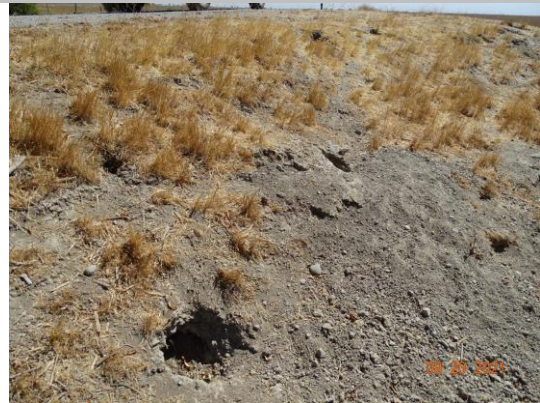
Photo 1 of 1 : FA_2024_NA0010_138_20_20240828_00011.jpg

LM Start	5.50	Rating **	M	Issue No.	20
LM End	5.50	Issue Type +	Ma	Location *	LS
Category	Earthen Levee			GPS Latitude/Longitude	
				Start	End
Item	Animal Control			37.272345 °	37.272345 °
				-120.741883 °	-120.741883 °
DWR ID	DWR_NA0010_22A_f_2021_20				
Comment Code					
A3 : No rodents visible, but rodent burrows visible; need to backfill and compact or grout burrows.					
Inspector Comment					
Rodent burrows observed on the landside turnout slope.

View of rodent holes in the landside slope looking upstream. (Fall 2021)

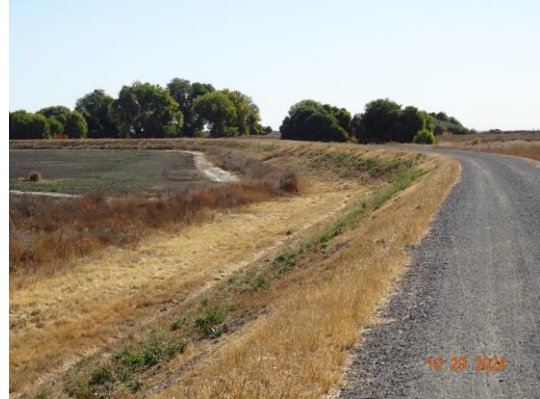
Photo 1 of 1 : FA_2024_NA0010_139_19_20241106_00033.jpg

LM Start	0.11	Rating **	A	Issue No.	19
LM End	0.11	Issue Type +	Ma	Location *	LS
Category	Earthen Levee			GPS Latitude/Longitude	
				Start	End
Item	Vegetation			36.773386°	36.773386°
				-120.282142°	-120.282142°
DWR ID	DWR_NA0010_23_f _ 2024_19				
Comment Code					
V1 : Control annual grass and weeds on the levee slopes and easements.					
Inspector Comment

Looking upstream along the landside slope. (Fall 2024)

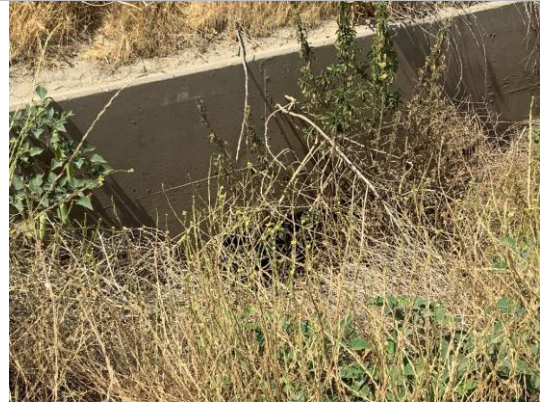
Photo 1 of 1 : UCIP_FA_2024_77877_102579.jpg

Comment Code						
Inspector Comment						
DS_ID:19945 FS_ID:77877 EP_NO: N/A Repair Type: Urgent EVAL Issue: 1, Pipe Integrity Crossing Status: Found UCIP Comments: 12/14/2022 Record updated from Non-Urgent to Urgent. DMP internal video inspection has found pipe integrity issues. LOF of crossing is between 5 and 6. Crossing will be monitored until funding becomes available to address the issues. (O.Yakimov - DWR UCIP) 07/19/2021 The record remains Non-Urgent. Dense LS vegetation over pipe inlet, recommend removal. No permit was found authorizing this encroachment. CVFPB will need to review crossing to determine owner. The UCIP inspection was completed with GEI staff, P. Espinoza. (H. Dunn ? GEI)04/03/2014 Excessive vegetation at inlet--recommend clearing. (W. Wylie - DWR UCIP) FIELD_STRUCT_DESC: 30-inch by 30-inch square reinforced concrete box gravity drainage culvert (RCBC) through the levee, 13.0 feet below the crown. Flap gate on the waterside (WS) end. Concrete headwall on the landside (LS) end. Concrete U-shaped headwall on the WS end. (Construction of a new discharge structure and rehabilitation of an existing diversion structure to return intercepted seepage to the San Joaquin River authorized under Permit No. 13085, 1981 - Diener, Dry River Farms). [Additional Reference(s): DWR Levee Log, 2002, (HLM 0.21). USACE San Joaquin O&M Manual, Unit No. 601, Part No. 1, 1967, Amended in 1978, Revised 20 June 1985, (HLM 0.21). DWR As-Built Specification No. 65-30, Sheet No. 7, 27 April 1965, (HLM 0.21), listed as 2'- 6" x 2'- 6" drainage structure]. FS Date: 7/19/2021 3:07:37 PM

LS view: Closeup of pipe inlet at toe covered with vegetation.

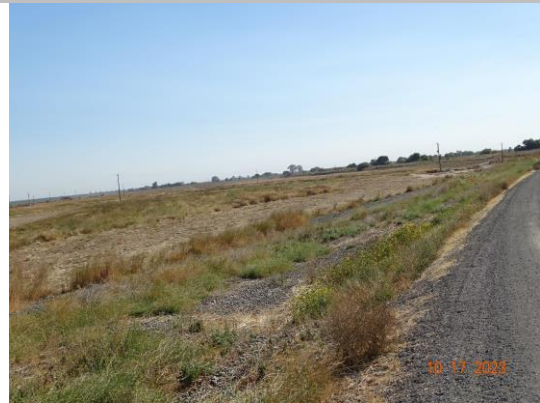
Photo 1 of 1 : FA_2024_NA0010_139_38_20240828_00008.jpg

LM Start	0.73	Rating **	A/W	Issue No.	38
LM End	1.51	Issue Type +	Ob	Location *	LS
Category	Earthen Levee			GPS Latitude/Longitude	
				Start	End
Item	Seepage / Sandboils			36.774702°	36.772158°
				-120.272638°	-120.259719°
DWR ID	DWR_NA0010_23_f_2023_38				
Comment Code					
SS : Seepage / Sandboils					
Inspector Comment					
Seepage blanket on landside toe installed during 2023 storms.

View of seepage blanket along the landside toe. (Fall 2023)

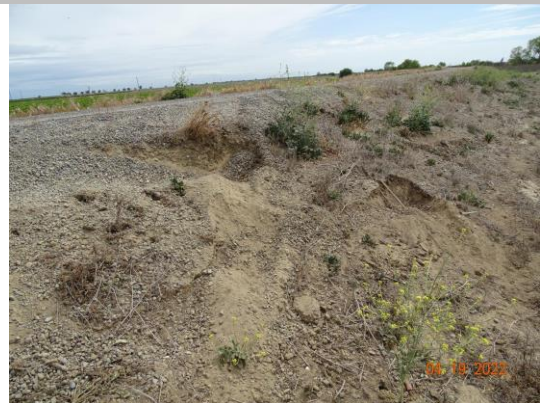
Photo 1 of 1 : FA_2024_NA0010_139_40_20240828_00009.jpg

LM Start	1.00	Rating **	M	Issue No.	40
LM End	1.00	Issue Type +	Ma	Location *	WS
Category	Earthen Levee			GPS Latitude/Longitude	
				Start	End
Item	Erosion / Vehicle Traffic			36.772875 °	36.772875 °
				-120.268436 °	-120.268436 °
DWR ID	DWR_NA0010_23_s_2022_40				
Comment Code					
E6 : Repair the levee slope damaged by vehicle traffic and prevent access where possible.					
Inspector Comment

Damage from vehicle traffic to the waterside slope. (Spring 2022)

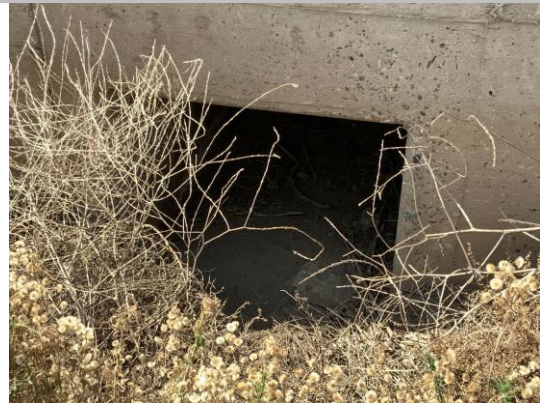
Photo 1 of 1 : UCIP_FA_2024_73578_102587.jpg

Comment Code						
Inspector Comment						
DS_ID:19948 FS_ID:73578 EP_NO: N/A Repair Type: Non-Urgent EVAL Issue: 11, Maintenance Compliance Issue Crossing Status: Found UCIP Comments: 07/19/2021 The record remains Non-Urgent. Sediment buildup inside LS pipe inlet, recommend cleaning out. WS flapgate inaccessible due to barbed wire. No permit was found authorizing this encroachment. CVFPB will need to review crossing to determine owner. The UCIP inspection was completed with GEI staff, P. Espinoza. (H. Dunn ? GEI)04/03/2014 Appears abandoned and if so should be done properly. Discharge channel is blocked by sand and soil making drain ineffective. Soil buildup at inlet on LS toe. Need to contact owner. (W. Wylie - DWR UCIP) FIELD_STRUCT_DESC: 30-inch by 30-inch square reinforced concrete box gravity drainage culvert (RCBC) through the levee, 11.0 feet below the crown. Flap gate on the waterside (WS) end. Concrete headwall on the landside (LS) end. Concrete U-shaped headwall on the WS end. [Additional Reference(s): DWR Levee Log, 2002, (HLM 1.64)]. FS Date: 7/19/2021

LS view: Closeup of pipe inlet at toe with sediment buildup.

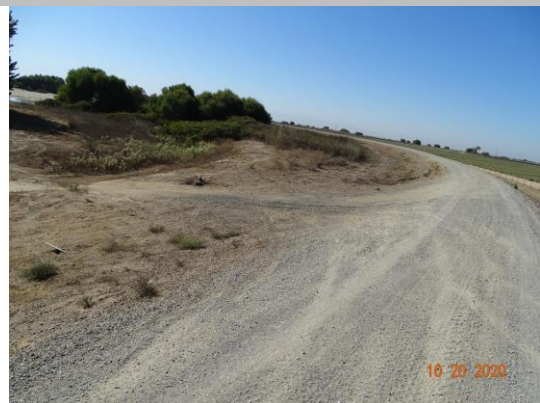
Photo 1 of 1 : FA_2024_NA0010_139_16_20240828_00002.jpg

LM Start	2.12	Rating **	M	Issue No.	16
LM End	2.12	Issue Type +	En	Location *	WS
Category	Earthen Levee			GPS Latitude/Longitude	
				Start	End
Item	Encroachments			36.775507 °	36.775507 °
				-120.251670 °	-120.251672 °
DWR ID	DWR_NA0010_23_s_2013_16				
Comment Code					
RA : Ramp					
Inspector Comment					
Ramp constructed on waterside slope.

View of ramp constructed on waterside slope. (Fall 2020)

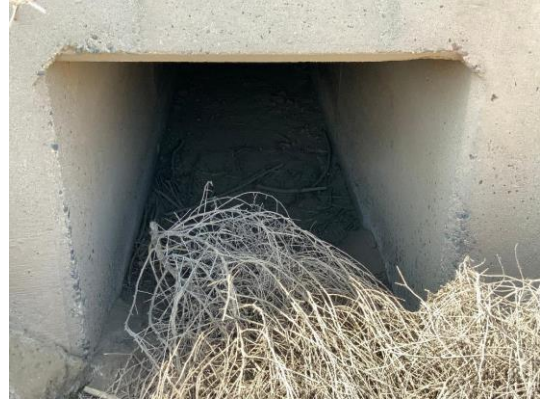
Photo 1 of 1 : UCIP_FA_2024_73579_102593.jpg

Comment Code					
Inspector Comment					
DS_ID:19951 FS_ID:73579 EP_NO: N/A Repair Type: Non-Urgent EVAL Issue: 11, Maintenance Compliance Issue Crossing Status: Found UCIP Comments: 07/19/2021 The record has been upgraded from No Action Needed to Non-Urgent. Sediment and tumbleweed buildup over and inside LS pipe inlet, recommend removal. No permit was found authorizing this encroachment. CVFPB will need to review crossing to determine owner. The UCIP inspection was completed with GEI staff, P. Espinoza. (H. Dunn ? GEI) FIELD_STRUCT_DESC: 30-inch by 30-inch square reinforced concrete box gravity drainage culvert (RCBC) through the levee, 9.0 feet below the crown. Flap gate on the waterside (WS) end. Concrete headwall on the landside (LS) end. Concrete U-shaped headwall on the WS end. [Additional Reference(s): DWR Levee Log, 2002, (HLM 2.99)]. FS Date: 7/19/2021

LS view: Closeup of pipe inlet at toe with sediment and vegetation buildup.

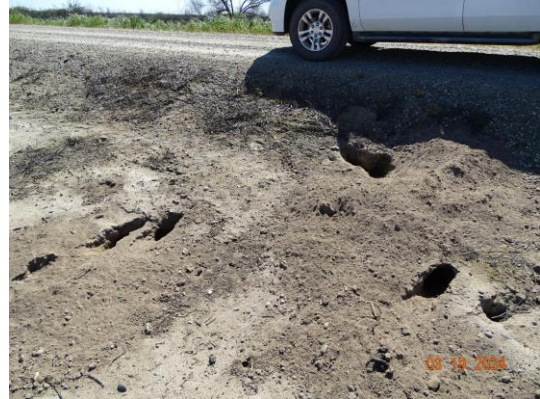
Photo 1 of 1 : FA_2024_NA0010_139_27_20240828_00006.jpg

LM Start	4.34	Rating **	A/W	Issue No.	27
LM End	4.34	Issue Type +	Ma	Location *	LS
Category	Earthen Levee			GPS Latitude/Longitude	
				Start	End
Item	Animal Control			36.783871 °	36.783871 °
				-120.225046 °	-120.225046 °
DWR ID	DWR_NA0010_23_s _ 2024_27				
Comment Code					
A3 : No rodents visible, but rodent burrows visible; need to backfill and compact or grout burrows.					
Inspector Comment

Multiple rodent holes observed at this section. (Spring 2024)

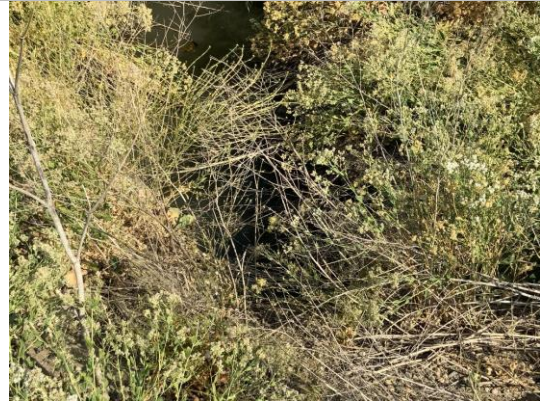
Photo 1 of 1 : UCIP_FA_2024_73581_102608.jpg

Comment Code					
Inspector Comment					
DS_ID:19953 FS_ID:73581 EP_NO: N/A Repair Type: Non-Urgent EVAL Issue: 11, Maintenance Compliance Issue Crossing Status: Found UCIP Comments: 07/19/2021 The record remains Non-Urgent. WS pipe inlet underwater during inspection. LS pipe outlet not visible due to dense vegetation, recommend removing vegetation. Limited inspection on both WS and LS ends. No permit was found authorizing this encroachment. CVFPB will need to review crossing to determine owner. The UCIP inspection was completed with GEI staff, P. Espinoza. (H. Dunn ? GEI)04/03/2014 Heavy vegetation at inlet and outlet-- recommend clearing. (W. Wylie - DWR UCIP) FIELD_STRUCT_DESC: 30-inch by 30-inch square reinforced concrete box gravity irrigation culvert (RCBC) through the levee, 10.7 feet below the crown. 4.5-foot by 7-foot concrete riser unit with slide gate on the waterside (WS) slope. Concrete U-shaped headwall on each end. 15-foot-long cobble revetted inlet channel. [Additional Reference(s): DWR Levee Log, 2002, (HLM 4.87)]. FS Date: 7/19/2021

LS view: Pipe outlet covered by dense vegetation at toe.

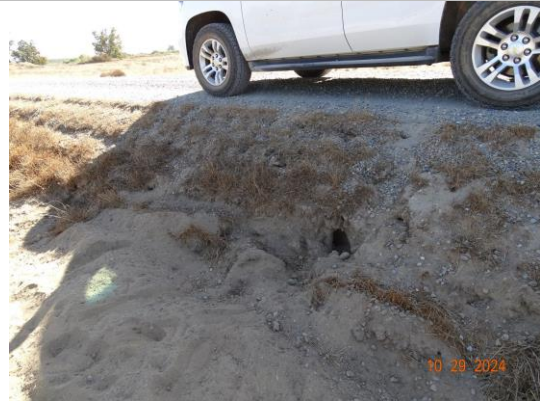
Photo 1 of 1 : FA_2024_NA0010_139_30_20241106_00034.jpg

LM Start	5.24	Rating **	M	Issue No.	30
LM End	5.24	Issue Type +	Ma	Location *	LS
Category	Earthen Levee			GPS Latitude/Longitude	
				Start	End
Item	Animal Control			36.791431 °	36.791431 °
				-120.213930 °	-120.213930 °
DWR ID	DWR_NA0010_23_f _ 2024_30				
Comment Code					
A3 : No rodents visible, but rodent burrows visible; need to backfill and compact or grout burrows.					
Inspector Comment

View of multiple rodent holes on the landside slope. (Fall 2024)

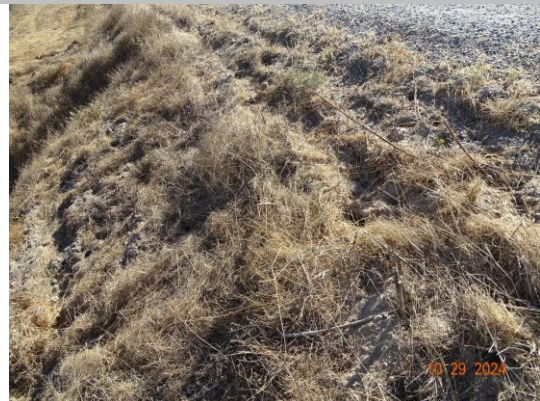
Photo 1 of 1 : FA_2024_NA0010_139_5_20241106_00035.jpg

LM Start	5.68	Rating **	M	Issue No.	5
LM End	5.68	Issue Type +	Ma	Location *	LS
Category	Earthen Levee			GPS Latitude/Longitude	
				Start	End
Item	Animal Control			36.791981 °	36.791981 °
				-120.206274 °	-120.206274 °
DWR ID	DWR_NA0010_23_s_2012_5				
Comment Code					
A1 : Exterminate rodents and backfill and compact or grout burrows.					
Inspector Comment					
There are several rodent holes downstream of the UCIP crossing.

View of rodent burrows on the landside slope. (Fall 2024)

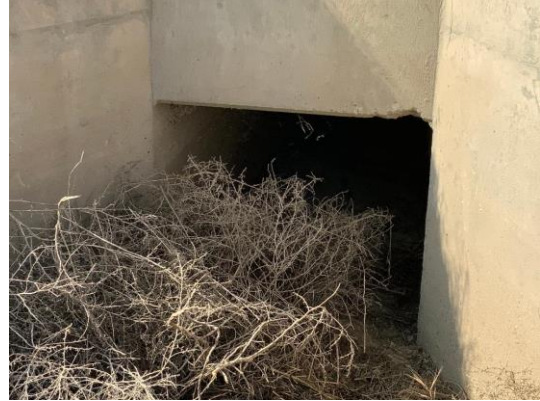
Photo 1 of 1 : UCIP_FA_2024_73582_102645.jpg

Comment Code						
Inspector Comment						
DS_ID:19954 FS_ID:73582 EP_NO: N/A Repair Type: Non-Urgent EVAL Issue: 11, Maintenance Compliance Issue Crossing Status: Found UCIP Comments: 07/19/2021 The record remains Non-Urgent. LS has sediment buildup in pipe inlet and buildup of tumbleweeds around pipe inlet, recommend clearing out. No permit was found authorizing this encroachment. CVFPB will need to review crossing to determine owner. The UCIP inspection was completed with GEI staff, P. Espinoza. (H. Dunn ? GEI)04/03/2014 Dense vegetation limits the inspector's visibility to identify signs of pipe failure (leaks) along the landward slope. Recommend removing vegetation along pipe alignment to conduct proper inspection of structure. (W. Wylie - DWR UCIP) FIELD_STRUCT_DESC: 36-inch by 36-inch square reinforced concrete box gravity drainage culvert (RCBC) through the levee, 9.0 feet below the crown. Flap gate on the waterside (WS) end. Concrete U-shaped headwall on each end. 5-foot-long cobble revetted outlet channel. [Additional Reference(s): DWR Levee Log, 2002, (HLM 5.71). USACE San Joaquin O&M Manual, Unit No. 601, Part No. 1, 1967, Amended in 1978, Revised 20 June 1985, (HLM 5.71). DWR As-Built Specification No. 65-30, Sheet No. 13, 27 April 1965, (HLM 5.71)]. FS Date: 7/19/2021

LS view: Closeup of pipe inlet at toe with sediment and tumbleweed buildup.

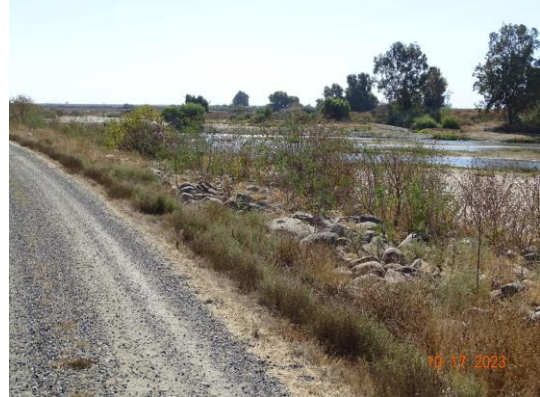
Photo 1 of 1 : FA_2024_NA0010_139_48_20240828_00013.jpg

LM Start	6.62	Rating **	A/W	Issue No.	48
LM End	6.71	Issue Type +	Ma	Location *	WS
Category	Earthen Levee			GPS Latitude/Longitude	
				Start	End
Item	Riprap Revetments			36.781585 °	36.780866 °
				-120.199345 °	-120.198009 °
DWR ID	DWR_NA0010_23_f _ 2023_48				
Comment Code					
RR : Riprap Revetments					
Inspector Comment

View of revetment placed on the waterside slope. (Fall 2023)

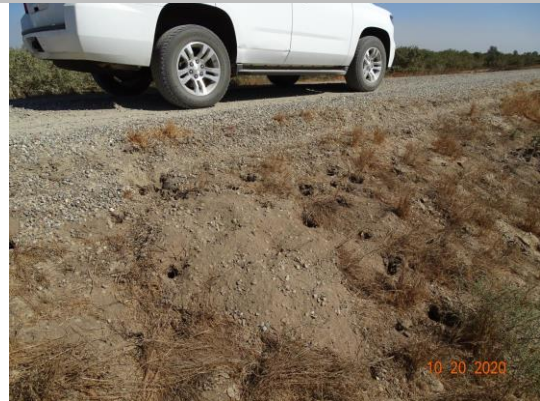
Photo 1 of 1 : FA_2024_NA0010_139_24_20240828_00004.jpg

LM Start	6.85	Rating **	A/W	Issue No.	24
LM End	6.85	Issue Type +	Ma	Location *	WS
Category	Earthen Levee			GPS Latitude/Longitude	
				Start	End
Item	Animal Control			36.780282 °	36.780282 °
				-120.195583 °	-120.195583 °
DWR ID	DWR_NA0010_23_f_2020_24				
Comment Code					
A3 : No rodents visible, but rodent burrows visible; need to backfill and compact or grout burrows.					
Inspector Comment

Several rodent holes noted at this location. (Fall 2020)

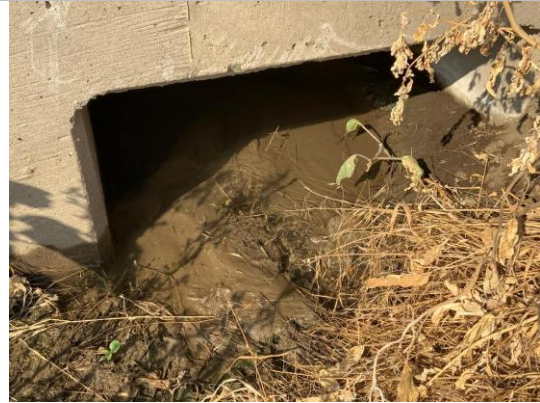
Photo 1 of 1 : UCIP_FA_2024_77874_102659.jpg

Comment Code						
Inspector Comment						
DS_ID:19939 FS_ID:77874 EP_NO: N/A Repair Type: Urgent EVAL Issue: 1, Pipe Integrity Crossing Status: Found UCIP Comments: 12/14/2022 Record updated from Non-Urgent to Urgent. DMP internal video inspection has found pipe integrity issues. LOF of crossing is between 5 and 6. Crossing will be monitored until funding becomes available to address the issues. (O.Yakimov - DWR UCIP) 07/19/2021 The record remains Non-Urgent. LS pipe inlet almost completely filled with sediment, recommend removal. Water running through WS flapgate during inspection and wooden plank keeping WS flapgate closed, recommend removal before flood season for better flow. No permit was found authorizing this encroachment. CVFPB will need to review crossing to determine owner. The UCIP inspection was completed with GEI staff, P. Espinoza. (H. Dunn ? GEI)04/03/2014 Dense vegetation limits the inspector's visibility to identify signs of pipe failure (leaks) along the landward slope. Recommend removing vegetation along pipe alignment to conduct proper inspection of structure. (W. Wylie - DWR UCIP) FIELD_STRUCT_DESC: 30-inch by 30-inch square reinforced concrete box gravity drainage culvert (RCBC) through the levee, 8.5 feet below the crown. Flap gate on the waterside (WS) end. Concrete headwall on the landside (LS) end. Concrete U-shaped headwall on the WS end. [Additional Reference(s): DWR Levee Log, 2002, (HLM 7.06)]. FS Date: 7/19/2021 3:06:24 PM

LS view: Closeup of pipe inlet at toe with dense sediment buildup.

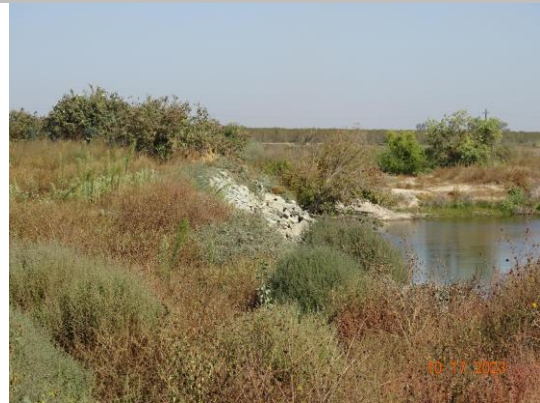
Photo 1 of 1 : FA_2024_NA0010_139_49_20240828_00014.jpg

LM Start	8.06	Rating **	A/W	Issue No.	49
LM End	8.13	Issue Type +	Ma	Location *	WS
Category	Earthen Levee			GPS Latitude/Longitude	
				Start	End
Item	Riprap Revetments			36.788957 °	36.789846 °
				-120.182361 °	-120.182235 °
DWR ID	DWR_NA0010_23_f_2023_49				
Comment Code					
RR : Riprap Revetments					
Inspector Comment

View of rock slope protection placed on the waterside berm. (Fall 2023)

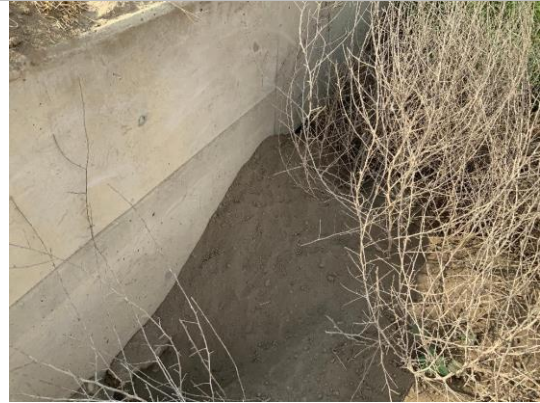
Photo 1 of 3 : UCIP_FA_2024_85076_102672.jpg

DS_ID:19940
FS_ID:85076
EP_NO: N/A
Repair Type: Non-Urgent
EVAL Issue: 5, Pipe Damage
Crossing Status: Found
UCIP Comments: 10/21/2024 Record updated from Urgent to Non-Urgent. Latest PACP inspection did not find SRC (reinforcement corroded) due to panning of camera. (O. Yakimov - DWR UCIP)
12/14/2022 Record updated from Non-Urgent to Urgent. DMP internal video inspection has found pipe integrity issues. LOF of crossing is between 5 and 6. Crossing will be monitored until funding becomes available to address the issues. (O.Yakimov - DWR UCIP)
07/19/2021 The record remains Non-Urgent. LS pipe inlet almost completely covered by sediment, recommend clearing out. Some minor erosion along one side of the WS headwall as well as some burrow complexes on the slope adjacent to same headwall side. No permit was found authorizing this encroachment. CVFPB will need to review crossing to determine owner. The UCIP inspection was completed with GEI staff, P. Espinoza. (H. Dunn ? GEI)04/03/2014 Some sediment buildup at inlet at LS toe. Also dense vegetation limits the inspector's visibility to identify signs of pipe failure (leaks) along the landward slope. Recommend removing vegetation along pipe alignment to conduct proper inspection of structure. (W. Wylie - DWR UCIP)

FIELD_STRUCT_DESC: 30-inch by 30-inch square reinforced concrete box gravity drainage culvert (RCBC) through the levee, 5.2 feet below the crown. Flap gate on the waterside (WS) end. Concrete headwall on the landside (LS) end. Concrete U-shaped headwall on the WS end.
[Additional Reference(s): DWR Levee Log, 2002, (HLM 8.33). USACE San Joaquin O&M Manual, Unit No. 601, Part No. 1, 1967, Amended in 1978, Revised 20 June 1985, (HLM 8.33). DWR As-Built Specification No. 65-30, Sheet No. 15, 27 April 1965, (HLM 8.33)].
FS Date: 7/19/2021 3:06:54 PM

LS view: Closeup of pipe inlet blocked by sediment.

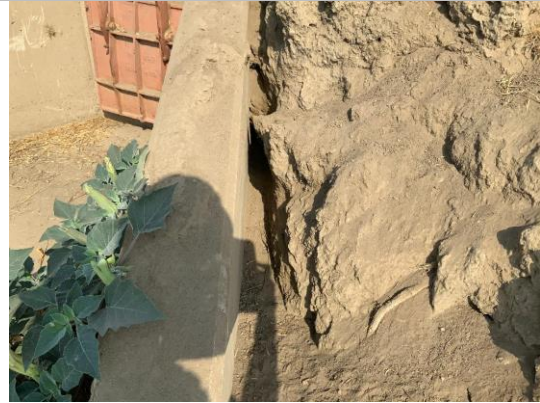
Photo 2 of 3 : UCIP_FA_2024_85076_102673.jpg

LM Start	8.32	Rating **	M	Issue No.	72 (cont)
LM End	8.32	Issue Type +	Ma	Location *	
Category	Supplemental			GPS Latitude/Longitude	
				Start	End
Item	DWR UCIP LMA Responsibility			36.792476°	36.792476°
				-120.181255°	-120.181255°
DWR ID	19940

WS view: Minor erosion along the side of the headwall at toe.

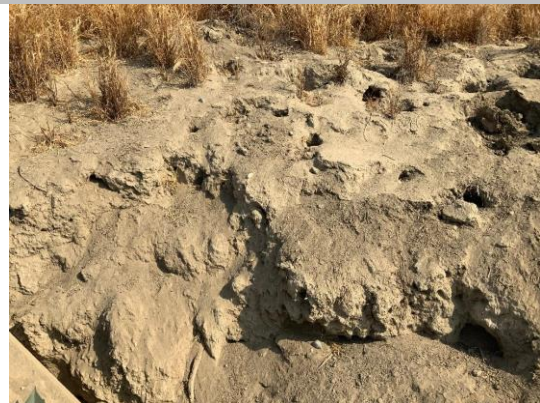
Photo 3 of 3 : UCIP_FA_2024_85076_102668.jpg

WS view: Burrow holes and erosion along the side of the headwall from toe.

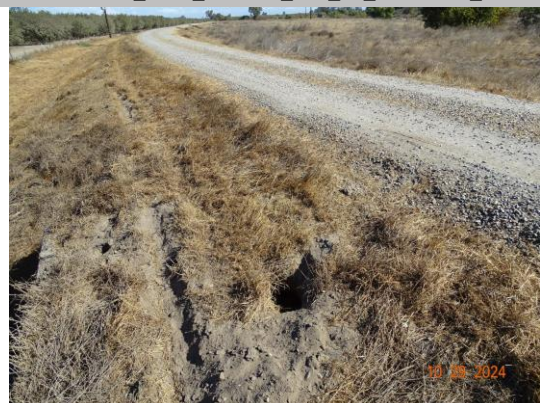
Photo 1 of 1 : FA_2024_NA0010_139_31_20241106_00036.jpg

LM Start	8.32	Rating **	M	Issue No.	31
LM End	8.32	Issue Type +	Ma	Location *	LS
Category	Earthen Levee			GPS Latitude/Longitude	
				Start	End
Item	Animal Control			36.792492 °	36.792492 °
				-120.181255 °	-120.181255 °
DWR ID	DWR_NA0010_23_f_2024_31				
Comment Code					
A3 : No rodents visible, but rodent burrows visible; need to backfill and compact or grout burrows.					
Inspector Comment

View of rodent burrows on the landside slope. (Fall 2024)

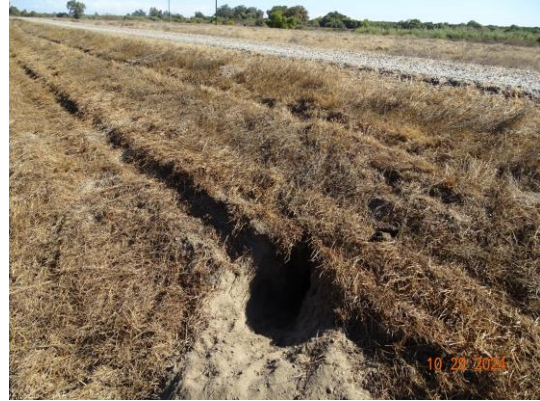
Photo 1 of 1 : FA_2024_NA0010_139_33_20241106_00037.jpg

LM Start	8.36	Rating **	M	Issue No.	33
LM End	8.36	Issue Type +	Ma	Location *	LS
Category	Earthen Levee			GPS Latitude/Longitude	
				Start	End
Item	Animal Control			36.792888 °	36.792888 °
				-120.180742 °	-120.180742 °
DWR ID	DWR_NA0010_23_f _ 2024_33				
Comment Code					
A3 : No rodents visible, but rodent burrows visible; need to backfill and compact or grout burrows.					
Inspector Comment

Large rodent holes observed on the landside slope. (Fall 2024)

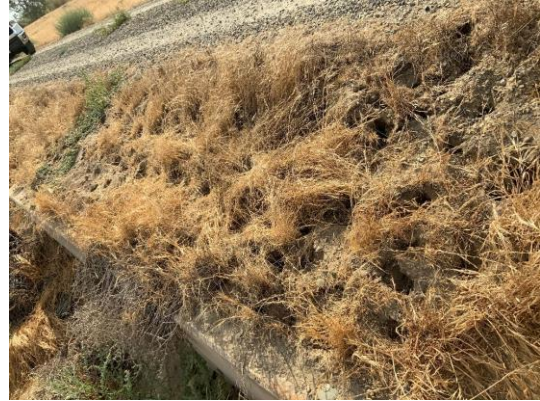
Photo 1 of 2 : UCIP_FA_2024_85077_102681.jpg

Comment Code						
Inspector Comment						
DS_ID:19941 FS_ID:85077 EP_NO: N/A Repair Type: Non-Urgent EVAL Issue: 11, Maintenance Compliance Issue Crossing Status: Found UCIP Comments: 10/21/2024 Record updated from Urgent to Non-Urgent. Latest PACP inspection did not find SRC (reinforcement corroded) due to panning of camera. (O. Yakimov - DWR UCIP) 12/14/2022 Record updated from Non-Urgent to Urgent. DMP internal video inspection has found pipe integrity issues. LOF of crossing is between 5 and 6. Crossing will be monitored until funding becomes available to address the issues. (O.Yakimov - DWR UCIP) 07/19/2021 The record remains Non-Urgent. LS pipe inlet has sediment buildup inside, recommend removal. Extensive burrows above the LS headwall slope. No permit was found authorizing this encroachment. CVFPB will need to review crossing to determine owner. The UCIP inspection was completed with GEI staff, P. Espinoza. (H. Dunn ? GEI) 04/03/2014 Dense vegetation limits the inspector's visibility to identify signs of pipe failure (leaks) along the landward slope. Recommend removing vegetation along pipe alignment to conduct proper inspection of structure. (W. Wylie - DWR UCIP) FIELD_STRUCT_DESC: 30-inch by 30-inch square reinforced concrete box gravity drainage culvert (RCBC) through the levee, 5.6 feet below the crown. Flap gate on the waterside (WS) end. Concrete headwall on the landside (LS) end. Concrete U-shaped headwall on the WS end. [Additional Reference(s): DWR Levee Log, 2002, (HLM 8.53). USACE San Joaquin O&M Manual, Unit No. 601, Part No. 1, 1967, Amended in 1978, Revised 20 June 1985, (HLM 8.54). DWR As-Built Specification No. 65-30, Sheet No. 15, 27 April 1965, (HLM 8.54)]. FS Date: 7/19/2021 3:07:17 PM

LS view: Burrow holes above headwall.

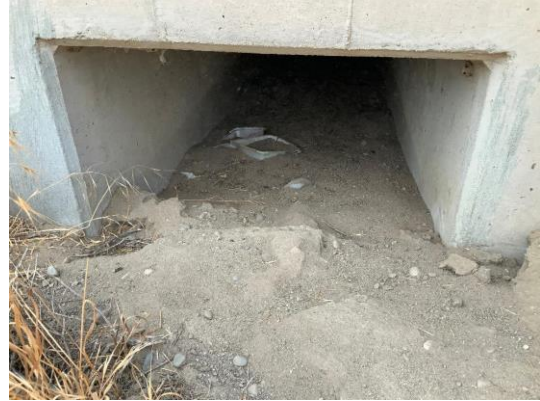
Photo 2 of 2 : UCIP_FA_2024_85077_102675.jpg

LM Start	8.52	Rating **	M	Issue No.	73 (cont)
LM End	8.52	Issue Type +	Ma	Location *	
Category	Supplemental			GPS Latitude/Longitude	
				Start	End
Item	DWR UCIP LMA Responsibility			36.794108 °	36.794108 °
				-120.178171 °	-120.178171 °
DWR ID	19941

LS view: Closeup of pipe inlet at toe with sediment buildup.

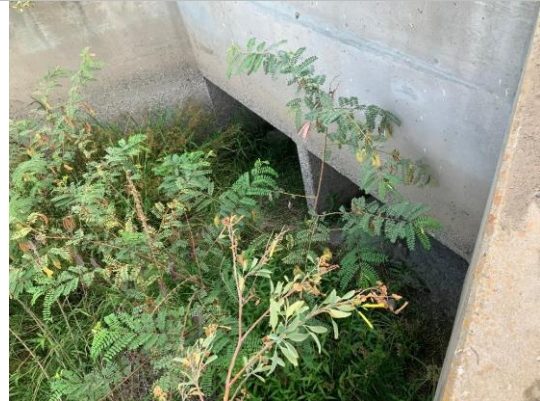
Photo 1 of 2 : UCIP_FA_2024_77382_102710.jpg

DS_ID:19943
FS_ID:77382
EP_NO: N/A
Repair Type: Urgent
EVAL Issue: 3a, Flood Risk
Crossing Status: Found
UCIP Comments: 08/31/2022 Crossing open on both ends with no way to close it as the gates do not work: urgent. (A. McDonald - DWR UCIP 7/19/2021 The record remains Non-Urgent. Limited access to both LS and WS due to steep slopes and vegetation. Both WS outlet and LS inlet have sediment buildup, recommend clearing out. No permit was found authorizing this encroachment. CVFPB will need to review crossing to determine owner. This portion of the levee has a levee prism less than 3 feet, appears to be high ground. The UCIP inspection was completed with GEI staff, P. Espinoza. (H. Dunn ? GEI)

11/01/2018 Limited access to both LS and WS; assumed slide gates are still non-functional; Crossing has been downgraded from Urgent to Non-Urgent due to re-classification of damage slide gates. (O. Magana - DWR UCIP 7/20/2016 No change--same as previous inspection. (O. Magana - DWR UCIP 4/03/2014 Slide gate not functional. Slide gate channels heavily corroded (exfoliated) and likely impact functionality/structural integrity of gate. (W. Wylie - DWR UCIP) FIELD_STRUCT_DESC: [Gravelly Ford Canal Irrigation Structure] 1 of 2: 48-inch by 63-inch reinforced concrete box gravity irrigation culvert (RCBC) through the levee, 10.0 feet below the crown. Concrete U-shaped headwall on each end. Gear pedestal slide gate with wall bracket on the waterside (WS) headwall. 10-foot-long cobble revetted outlet channel. Guardrail on each shoulder. Slide gates on the WS. [Additional Reference(s): DWR Levee Log, 2002, (HLM 9.76). USACE San Joaquin O&M Manual, Unit No. 601, Part No. 1, 1967, Amended in 1978, Revised 20 June 1985, (HLM 9.76). DWR As-Built Specification No. 65-30, Sheet No. 16, 27 April 1965, (HLM 9.76)].

LS view: Closeup of inlets at toe with sediment buildup.

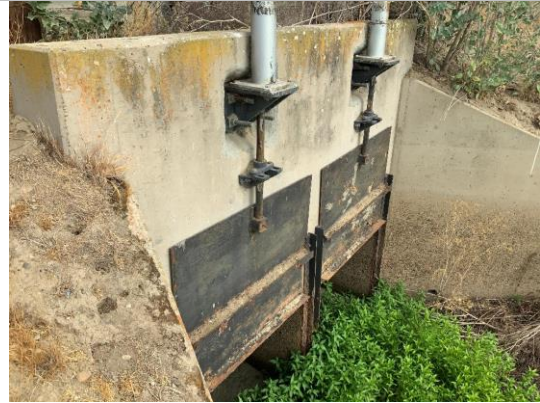
Photo 2 of 2 : UCIP_FA_2024_77382_102713.jpg

LM Start	9.75	Rating **	U	Issue No.	74 (cont)
LM End	9.75	Issue Type +	En	Location *	
Category	Supplemental			GPS Latitude/Longitude	
				Start	End
Item	DWR UCIP Field Study			36.807768 °	36.807768 °
				-120.168848 °	-120.168848 °
DWR ID	19943

WS view: Closeup of slidegates at toe.

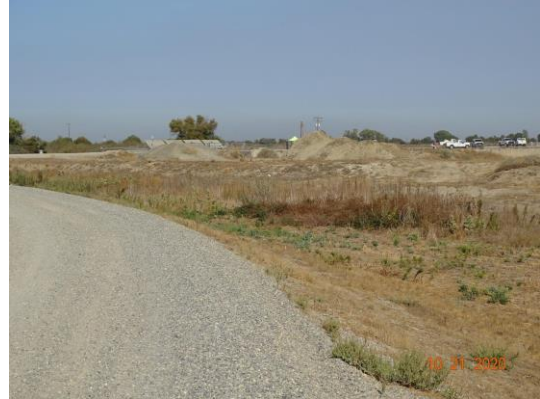
Photo 1 of 1 : FA_2024_NA0010_140_47_20240828_00013.jpg

LM Start	0.06	Rating **	M	Issue No.	47
LM End	0.06	Issue Type +	En	Location *	WS
Category	Earthen Levee			GPS Latitude/Longitude	
				Start	End
Item	Encroachments			36.772328 °	36.772328 °
				-120.285117 °	-120.285117 °
DWR ID	DWR_NA0010_24_s_2014_47				
Comment Code					
MA : Material					
Inspector Comment					
The District constructed a berm on waterside slope. The berm is being used for staging of earthen material.

Berm and material constructed off the waterside slope. (Fall 2020)

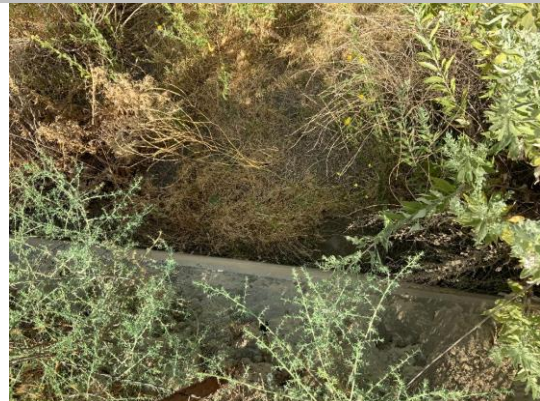
Photo 1 of 2 : UCIP_FA_2024_77878_102764.jpg

Comment Code					
Inspector Comment					
DS_ID:19955 FS_ID:77878 EP_NO: N/A Repair Type: Urgent EVAL Issue: 1, Pipe Integrity Crossing Status: Found UCIP Comments: 12/14/2022 Record updated from Non-Urgent to Urgent. DMP internal video inspection has found pipe integrity issues. LOF of crossing is between 5 and 6. Crossing will be monitored until funding becomes available to address the issues. (O.Yakimov - DWR UCIP) 07/20/2021 The record remains Non-Urgent. Cannot access LS inlet due to barbed wire, but appears to have sediment buildup. WS flapgate inaccessible due to steep hill and dense vegetation, recommend clearing vegetation and sediment out on both WS and LS inlet/outlet. No permit was found authorizing this encroachment. CVFPB will need to review crossing to determine owner. The UCIP inspection was completed with GEI staff, P. Espinoza. (H. Dunn ? GEI) 04/08/2014 No access available to confirm condition of landward side headwall. Recommend clearing debris along fence. Surface erosion near concrete headwall on landward side was present. (O. Magana - DWR UCIP) FIELD_STRUCT_DESC: 30-inch by 30-inch square reinforced concrete box gravity drainage culvert (RCBC) through the levee, 13.5 feet below the crown. Flap gate on the waterside (WS) end. Concrete headwall on each end. [Additional Reference(s): DWR Levee Log, 2002, (HLM 0.49)]. FS Date: 7/20/2021 3:10:19 PM

LS view: Top of headwall at toe.

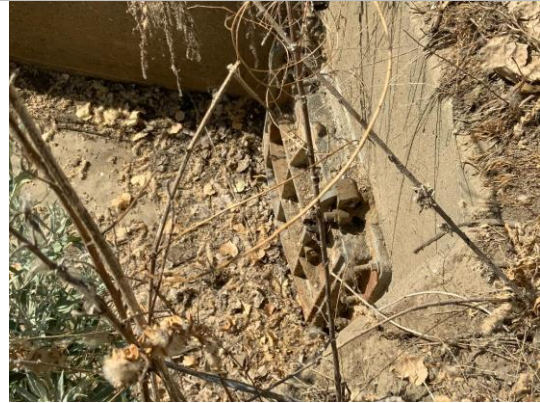
Photo 2 of 2 : UCIP_FA_2024_77878_102761.jpg

LM Start	0.50	Rating **	U	Issue No.	52 (cont)
LM End	0.50	Issue Type +	En	Location *	
Category	Supplemental			GPS Latitude/Longitude	
				Start	End
Item	DWR UCIP Field Study			36.766872 °	36.766872 °
				-120.283212 °	-120.283212 °
DWR ID	19955

WS view: Closeup of flapgate at toe.

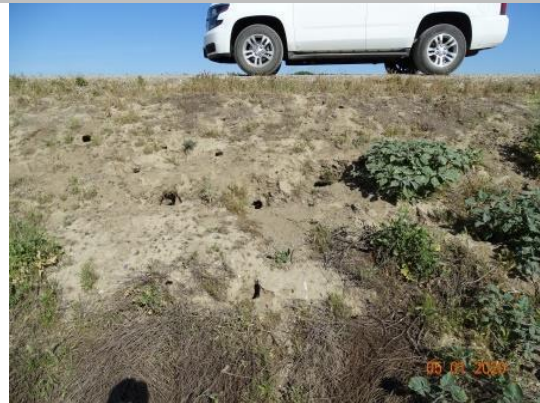
Photo 1 of 1 : FA_2024_NA0010_140_6_20240828_00001.jpg

LM Start	0.80	Rating **	A/W	Issue No.	6
LM End	0.84	Issue Type +	Ma	Location *	LS
Category	Earthen Levee			GPS Latitude/Longitude	
				Start	End
Item	Animal Control			36.766553 °	36.766962 °
				-120.278947 °	-120.278602 °
DWR ID	DWR_NA0010_24_s_2013_6				
Comment Code					
A1 : Exterminate rodents and backfill and compact or grout burrows.					
Inspector Comment					
There are several rodent holes identified within this section.

Rodent burrows in the landside slope. (Spring 2020)

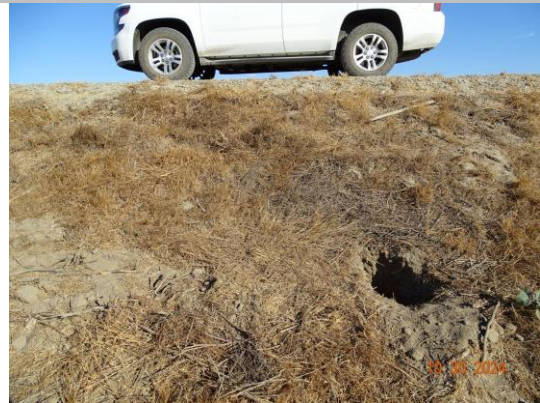
Photo 1 of 1 : FA_2024_NA0010_140_24_20241106_00026.jpg

LM Start	1.87	Rating **	M	Issue No.	24
LM End	1.87	Issue Type +	Ma	Location *	LS
Category	Earthen Levee			GPS Latitude/Longitude	
				Start	End
Item	Animal Control			36.771660 °	36.771660 °
				-120.264201 °	-120.264201 °
DWR ID	DWR_NA0010_24_f_2024_24				
Comment Code					
A3 : No rodents visible, but rodent burrows visible; need to backfill and compact or grout burrows.					
Inspector Comment

View of large rodent hole on the landside slope. (Fall 2024)

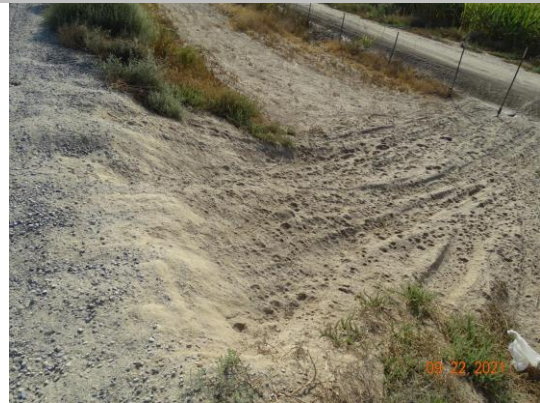
Photo 1 of 1 : FA_2024_NA0010_140_39_20240828_00012.jpg

LM Start	2.77	Rating **	A/W	Issue No.	39
LM End	2.77	Issue Type +	Ma	Location *	LS
Category	Earthen Levee			GPS Latitude/Longitude	
				Start	End
Item	Erosion / Vehicle Traffic			36.772289 °	36.772289 °
				-120.249693 °	-120.249693 °
DWR ID	DWR_NA0010_24_f_2021_39				
Comment Code					
E6 : Repair the levee slope damaged by vehicle traffic and prevent access where possible.					
Inspector Comment

View of the vehicle traffic on the landside slope. (Fall 2021)

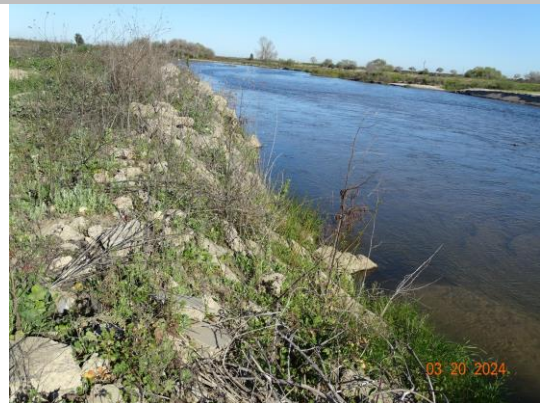
Photo 1 of 1 : FA_2024_NA0010_140_17_20240828_00004.jpg

LM Start	2.79	Rating **	A/W	Issue No.	17
LM End	2.87	Issue Type +	Ma	Location *	WS
Category	Earthen Levee			GPS Latitude/Longitude	
				Start	End
Item	Riprap Revetments			36.772501 °	36.771801 °
				-120.249368 °	-120.248057 °
DWR ID	DWR_NA0010_24_s_2024_17				
Comment Code					
RR : Riprap Revetments					
Inspector Comment

View of revetment placed on the waterside slope and berm. (Spring 2024)

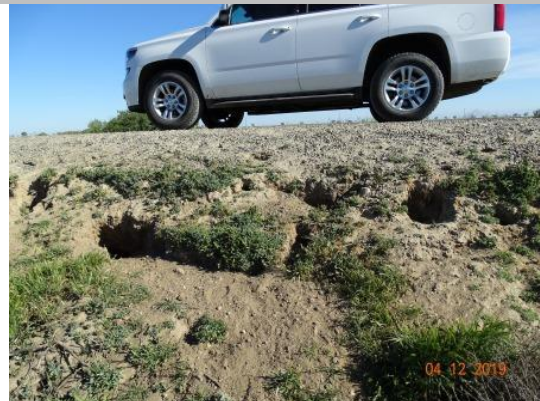
Photo 1 of 1 : FA_2024_NA0010_140_51_20240828_00014.jpg

LM Start	3.05	Rating **	U	Issue No.	51
LM End	3.20	Issue Type +	Ma	Location *	LS
Category	Earthen Levee			GPS Latitude/Longitude	
				Start	End
Item	Animal Control			36.770146 °	36.769796 °
				-120.245703 °	-120.243035 °
DWR ID	DWR_NA0010_24_s_2019_51				
Comment Code					
A3 : No rodents visible, but rodent burrows visible; need to backfill and compact or grout burrows.					
Inspector Comment

View of rodent holes in landside slope. (Spring 2019)

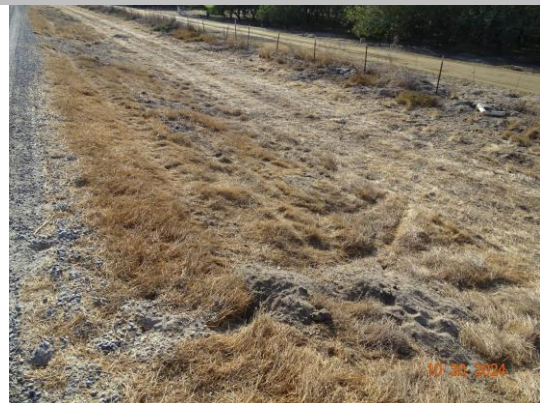
Photo 1 of 1 : FA_2024_NA0010_140_21_20241106_00027.jpg

LM Start	3.53	Rating **	M	Issue No.	21
LM End	3.53	Issue Type +	Ma	Location *	LS
Category	Earthen Levee			GPS Latitude/Longitude	
				Start	End
Item	Animal Control			36.768895 °	36.768895 °
				-120.237224 °	-120.237224 °
DWR ID	DWR_NA0010_24_f_2024_21				
Comment Code					
A3 : No rodents visible, but rodent burrows visible; need to backfill and compact or grout burrows.					
Inspector Comment

View of animal burrows on the landside slope and toe. (Fall 2024)

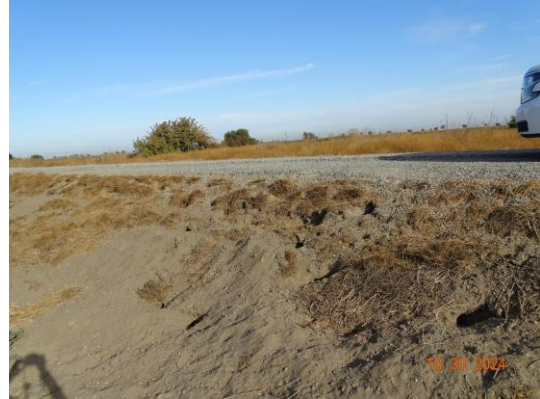
Photo 1 of 1 : FA_2024_NA0010_140_18_20241106_00028.jpg

LM Start	3.56	Rating **	U	Issue No.	18
LM End	3.56	Issue Type +	Ma	Location *	LS
Category	Earthen Levee			GPS Latitude/Longitude	
				Start	End
Item	Animal Control			36.768716 °	36.768716 °
				-120.236748 °	-120.236748 °
DWR ID	DWR_NA0010_24_f_2024_18				
Comment Code					
A3 : No rodents visible, but rodent burrows visible; need to backfill and compact or grout burrows.					
Inspector Comment

Multiple large rodent burrows observed in this section. (Fall 2024)

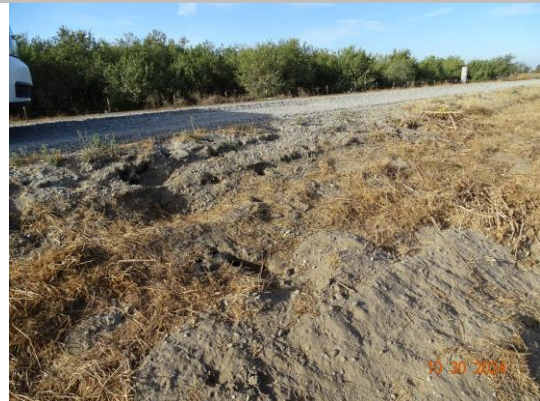
Photo 1 of 1 : FA_2024_NA0010_140_11_20241106_00029.jpg

LM Start	3.56	Rating **	M	Issue No.	11
LM End	3.56	Issue Type +	Ma	Location *	WS
Category	Earthen Levee			GPS Latitude/Longitude	
				Start	End
Item	Animal Control			36.768714 °	36.768714 °
				-120.236747 °	-120.236747 °
DWR ID	DWR_NA0010_24_f_2024_11				
Comment Code					
A3 : No rodents visible, but rodent burrows visible; need to backfill and compact or grout burrows.					
Inspector Comment

View of several rodent holes on the waterside slope. (Fall 2024)

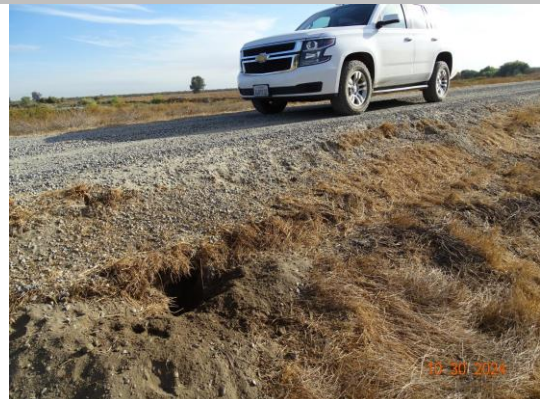
Photo 1 of 1 : FA_2024_NA0010_140_28_20241106_00030.jpg

LM Start	3.58	Rating **	U	Issue No.	28
LM End	3.58	Issue Type +	Ma	Location *	LS
Category	Earthen Levee			GPS Latitude/Longitude	
				Start	End
Item	Animal Control			36.768548 °	36.768548 °
				-120.236333 °	-120.236333 °
DWR ID	DWR_NA0010_24_f_2019_28				
Comment Code					
A3 : No rodents visible, but rodent burrows visible; need to backfill and compact or grout burrows.					
Inspector Comment

View of rodent burrows in the landside slope. (Fall 2024)

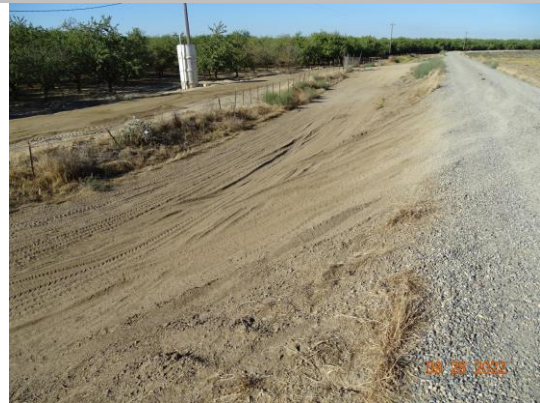
Photo 1 of 1 : FA_2024_NA0010_140_37_20240828_00011.jpg

LM Start	3.84	Rating **	A/W	Issue No.	37
LM End	3.84	Issue Type +	Ma	Location *	LS
Category	Earthen Levee			GPS Latitude/Longitude	
				Start	End
Item	Erosion / Vehicle Traffic			36.768024 °	36.768024 °
				-120.231896 °	-120.231896 °
DWR ID	DWR_NA0010_24_f_2022_37				
Comment Code					
E6 : Repair the levee slope damaged by vehicle traffic and prevent access where possible.					
Inspector Comment

View of the vehicle paths on the landside slope. (Fall 2022)

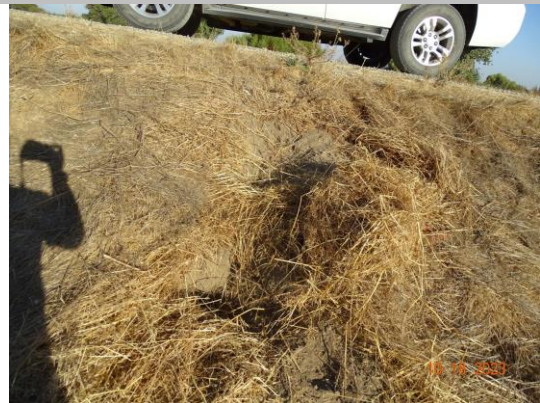
Photo 1 of 1 : FA_2024_NA0010_140_33_20240828_00010.jpg

LM Start	4.01	Rating **	M	Issue No.	33
LM End	4.01	Issue Type +	Ma	Location *	LS
Category	Earthen Levee			GPS Latitude/Longitude	
				Start	End
Item	Animal Control			36.768686 °	36.768686 °
				-120.229036 °	-120.229036 °
DWR ID	DWR_NA0010_24_f_2023_33				
Comment Code					
A3 : No rodents visible, but rodent burrows visible; need to backfill and compact or grout burrows.					
Inspector Comment

View of rodent burrows on the landside slope. (Fall 2023)

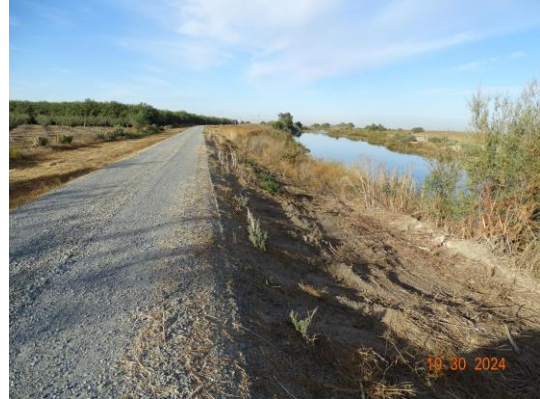
Photo 1 of 1 : FA_2024_NA0010_140_10_20241106_00031.jpg

LM Start	5.31	Rating **	A/W	Issue No.	10
LM End	5.37	Issue Type +	Ma	Location *	WS
Category	Earthen Levee			GPS Latitude/Longitude	
				Start	End
Item	Riprap Revetments			36.781998°	36.782245°
				-120.224323°	-120.223360°
DWR ID	DWR_NA0010_24_f _ 2024_10				
Comment Code					
RR : Riprap Revetments					
Inspector Comment

View of revetment place on the waterside slope. (Fall 2024)

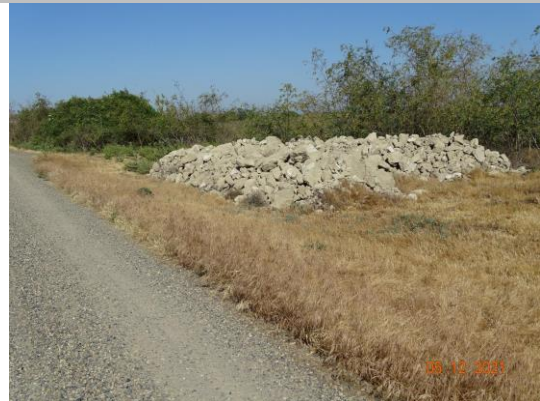
Photo 1 of 1 : FA_2024_NA0010_140_25_20240828_00007.jpg

LM Start	5.40	Rating **	M	Issue No.	25
LM End	5.40	Issue Type +	En	Location *	WS
Category	Earthen Levee			GPS Latitude/Longitude	
				Start	End
Item	Encroachments			36.782397 °	36.782397 °
				-120.222815 °	-120.222815 °
DWR ID	DWR_NA0010_24_s_2021_25				
Comment Code					
MA : Material					
Inspector Comment					
Rocks are stockpiled near the waterside toe.

Stockpile of rock kept at the waterside toe and river channel. (Spring 2021)

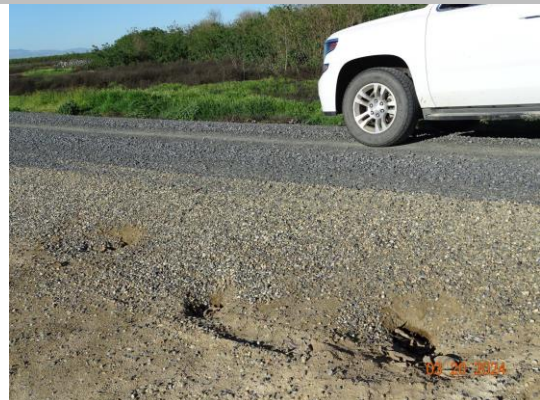
Photo 1 of 1 : FA_2024_NA0010_140_20_20240828_00006.jpg

LM Start	5.66	Rating **	M	Issue No.	20
LM End	5.66	Issue Type +	Ma	Location *	LS
Category	Earthen Levee			GPS Latitude/Longitude	
				Start	End
Item	Animal Control			36.784215 °	36.784215 °
				-120.218882 °	-120.218882 °
DWR ID	DWR_NA0010_24_f_2020_20				
Comment Code					
A3 : No rodents visible, but rodent burrows visible; need to backfill and compact or grout burrows.					
Inspector Comment

View of rodent holes at the landside toe. (Spring 2024)

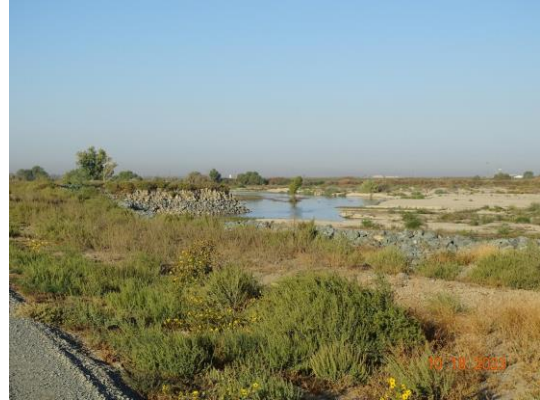
Photo 1 of 1 : FA_2024_NA0010_140_32_20240828_00009.jpg

LM Start	5.99	Rating **	A/W	Issue No.	32
LM End	6.10	Issue Type +	Ma	Location *	WS
Category	Earthen Levee			GPS Latitude/Longitude	
				Start	End
Item	Riprap Revetments			36.787422 °	36.787874 °
				-120.215689 °	-120.213838 °
DWR ID	DWR_NA0010_24_f _ 2023_32				
Comment Code					
RR : Riprap Revetments					
Inspector Comment

View of revetment placed on the waterside berm. (Fall 2023)

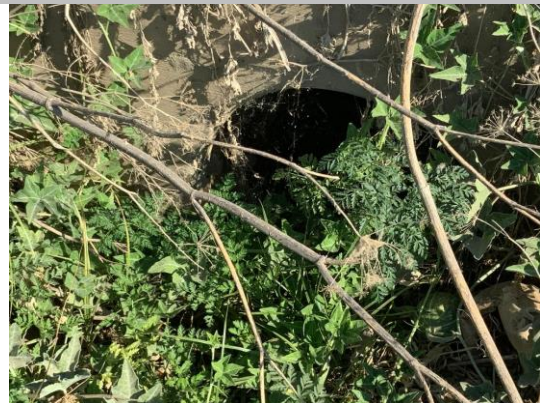
Photo 1 of 1 : UCIP_FA_2024_73634_102808.jpg

UCIP Comments: 09/25/2024 DMP internal video inspection has found moderate pipe defects. Crossing will be monitored until funding becomes available for rehabilitation. (O. Yakimov - DWR UCIP)

07/20/2021 The record has been upgraded from No Action Needed to Non-Urgent. Limited inspection due to some vegetation covering LS pipe inlet, recommend removal. No permit has been identified authorizing pipe. Levee prism appears less than 3 feet in height. The UCIP inspection was completed with GEI staff, P. Espinoza. (H. Dunn ? GEI)

LS view: Closeup of pipe inlet at toe covered by vegetation.

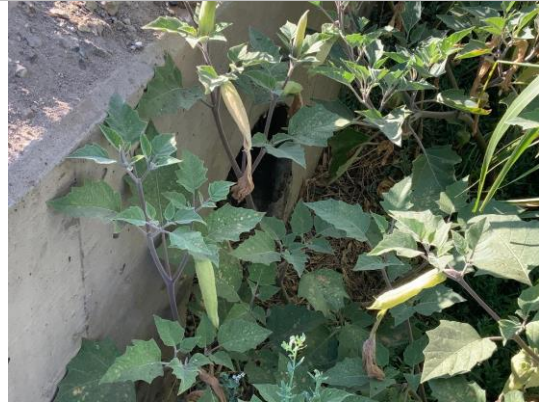
Photo 1 of 1 : UCIP_FA_2024_73635_102814.jpg

Comment Code						
Inspector Comment						
DS_ID:19957 FS_ID:73635 EP_NO: N/A Repair Type: Non-Urgent EVAL Issue: 5, Pipe Damage Crossing Status: Found UCIP Comments: 09/25/2024 DMP internal video inspection has found moderate pipe defects. Crossing will be monitored until funding becomes available for rehabilitation. (O. Yakimov - DWR UCIP) 07/20/2021 The record remains Non-Urgent. Limited inspection due to some vegetation covering LS pipe inlet, recommend removal. No permit was found authorizing this encroachment. The levee prism appears to be less than 3 feet. The UCIP inspection was completed with GEI staff, P. Espinoza. (H. Dunn ? GEI)7/20/2016 same as previous inspection. Crossing has been downgraded from Urgent to Non-Urgent PVC does not prevent WS flap gate from closing. (O. Magana - DWR UCIP)4/08/2014 Unauthorized PVC pipe through existing crossing. PVC distorted inside--Need to contact owner to correct issue. If crossing was allowed need to contact owner for permit number issue for crossing variance. (O. Magana - DWR UCIP) FIELD_STRUCT_DESC: 24-inch corrugated metal gravity drainage pipe (CMP) through the levee, 3.6 feet below the crown. Flap gate on the waterside (WS) end. Concrete headwall on the landside (LS) end. Concrete U-shaped headwall on the WS end. [Additional Reference(s): DWR Levee Log, 2002, (HLM 6.72). DWR As-Built Drawing No. 65-30, 27 April 1965, Sheet 13, STA 364+00]. FS Date: 7/20/2021

LS view: Closeup of pipe inlet at toe with vegetation overgrowth.

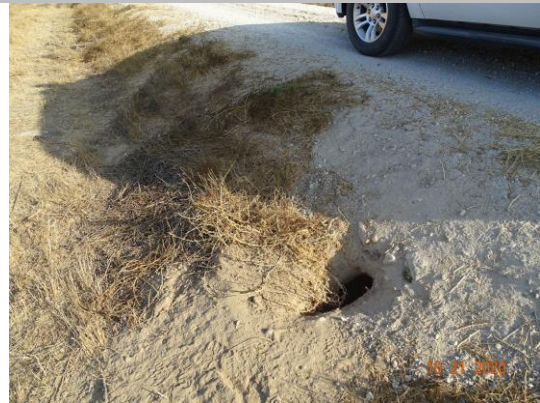
Photo 1 of 1 : FA_2024_NA0010_140_14_20240828_00003.jpg

LM Start	6.86	Rating **	A/W	Issue No.	14
LM End	6.86	Issue Type +	Ma	Location *	LS
Category	Earthen Levee			GPS Latitude/Longitude	
				Start	End
Item	Animal Control			36.784716 °	36.784716 °
				-120.204043 °	-120.204043 °
DWR ID	DWR_NA0010_24_f_2020_14				
Comment Code					
A3 : No rodents visible, but rodent burrows visible; need to backfill and compact or grout burrows.					
Inspector Comment

Rodent burrow on the landside slope. (Fall 2020)

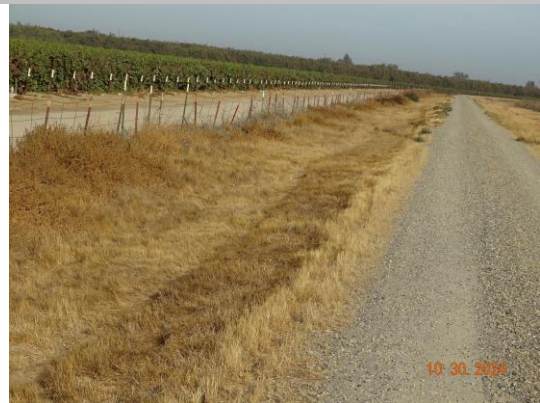
Photo 1 of 1 : FA_2024_NA0010_140_9_20241106_00032.jpg

LM Start	7.25	Rating **	A	Issue No.	9
LM End	7.25	Issue Type +	Ma	Location *	LS
Category	Earthen Levee			GPS Latitude/Longitude	
				Start	End
Item	Vegetation			36.780152°	36.780152°
				-120.200157°	-120.200157°
DWR ID	DWR_NA0010_24_f_2024_9				
Comment Code					
V1 : Control annual grass and weeds on the levee slopes and easements.					
Inspector Comment

View of vegetation management on the landside slope. (Fall 2024)

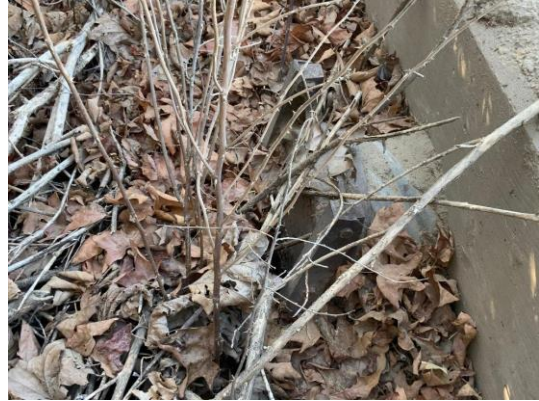
Photo 2 of 2 : UCIP_FA_2024_73636_102832.jpg

LM Start	7.64	Rating **	M	Issue No.	55 (cont)
LM End	7.64	Issue Type +	Ma	Location *	
Category	Supplemental			GPS Latitude/Longitude	
				Start	End
Item	DWR UCIP LMA Responsibility			36.775949 °	36.775949 °
				-120.195636 °	-120.195636 °
DWR ID	19958

WS view: Closeup of flapgate at toe with vegetation debris.

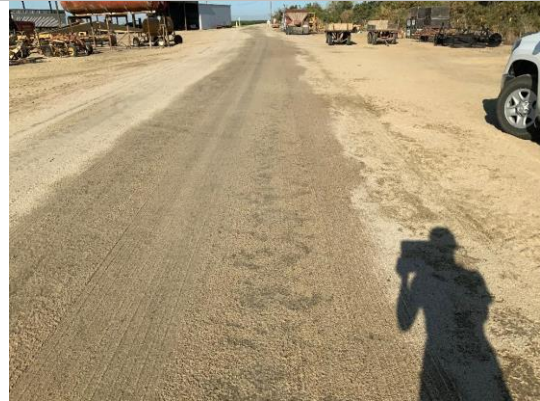
Photo 1 of 3 : UCIP_FA_2024_73637_102857.jpg

Levee crown.

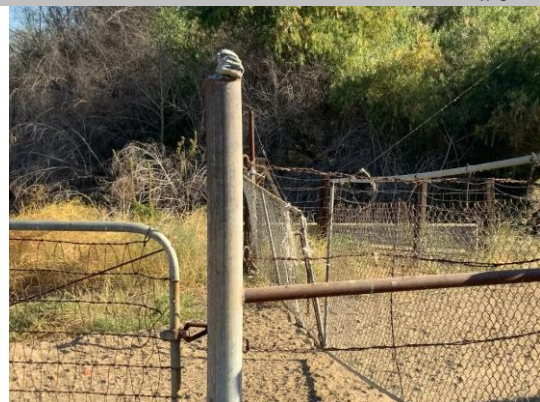
Photo 2 of 3 : UCIP_FA_2024_73637_102856.jpg

DS_ID:19959
FS_ID:73637
EP_NO: N/A
Repair Type: Non-Urgent
EVAL Issue:
Crossing Status: Indicator Found
UCIP Comments: 07/20/2021 The record is Non-Urgent. Possible WS headwall visible from the crown but inaccessible due to fences, limited inspection. Appears removed or abandoned due to no cobble outlet channel or outlet visible on the LS. LS end is completely flat and adjacent to a working farm. DWR DMP geophysical study did not confirm presence of pipe through levee. Record will remain in UCIP's inspection records until future Levee Improvement Project can confirm no crossing was found through the levee. No permit was found authorizing this encroachment. CVFPB will need to review crossing to determine owner. Levee prism appears to be less than 3 feet in height. The UCIP inspection was completed with GEI staff, P. Espinoza. (H. Dunn ? GEI)
FIELD_STRUCT_DESC: 36-inch reinforced concrete gravity drainage pipe (RCP) through the levee, 10.5 feet below the crown. Flap gate on the waterside (WS) end. Concrete headwall on the WS end. 10-foot cobble revetted outlet channel. [Additional Reference(s): DWR Levee Log, 2002, (HLM 8.16). USACE San Joaquin O&M Manual, Unit No. 601, Part No. 1, 1967, Amended in 1978, Revised 20 June 1985, (HLM 8.15). DWR As-Built Specification No. 65-30, Sheet No. 14, 27 April 1965, (HLM 8.15)].

LS view: Top of a headwall barely visible behind fences from crown.
