Flood Control Project Maintenance Levee Inspections

Fall 2024 Levee Maintenance Deficiency Summary Report

San Joaquin River Basin

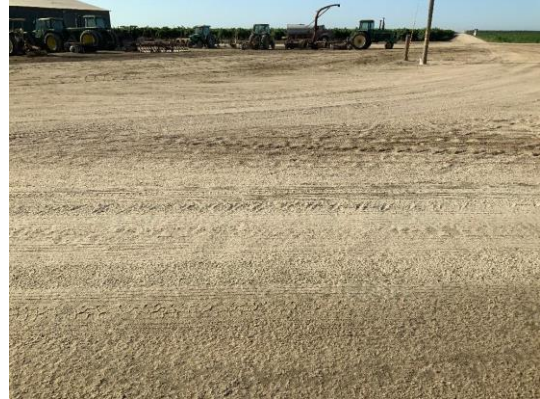
Photo 3 of 3 : UCIP_FA_2024_73637_102858.jpg

LM Start	8.16	Rating **	M	Issue No.	56 (cont)
LM End	8.16	Issue Type +	Ma	Location *	
Category	Supplemental		GPS Latitude/Longitude		
			Start	End	
Item	DWR UCIP LMA Responsibility		36.776638 °	36.776638 °	
			-120.186738 °	-120.186738 °	
DWR ID	19959

WS view: Toe from crown, no pipe visible.

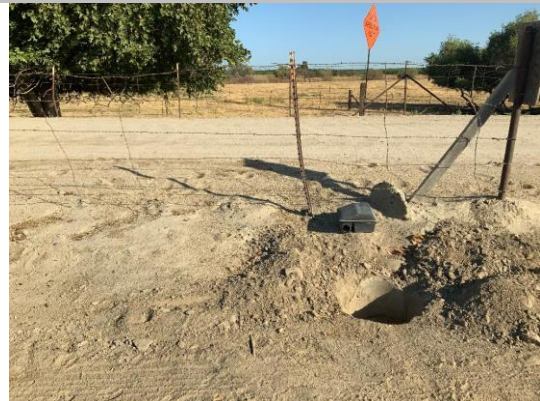
Photo 1 of 2 : UCIP_FA_2024_73638_102864.jpg

LS view: Slope from toe, no pipe visible.

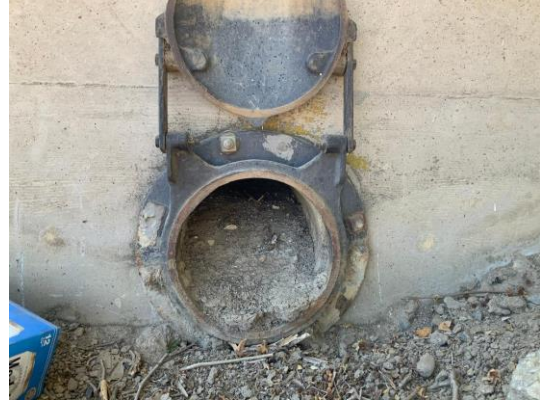
Photo 2 of 2 : UCIP_FA_2024_73638_102862.jpg

DS_ID:19960
FS_ID:73638
EP_NO: N/A
Repair Type: Non-Urgent
EVAL Issue: 11, Maintenance Compliance Issue
Crossing Status: Found
UCIP Comments: 07/20/2021 The record remains Non-Urgent. WS outlet filled with sediment, recommend cleaning out. LS pipe inlet not found, likely buried under dirt, recommend removal. No permit was found authorizing this encroachment. CVFPB will need to review crossing to determine owner. Levee prism appears to be less than 3 feet in height. The UCIP inspection was completed with GEI staff, P. Espinoza. (H. Dunn ? GEI)04/08/2014 Barbed wire along levee shoulder--no access. Need to confirm crossing size and condition of crossing. (O. Magana - DWR UCIP)
FIELD_STRUCT_DESC: 12-inch reinforced concrete gravity drainage pipe (RCP) through the levee, 3.0 feet below the crown. Flap gate on the waterside (WS) end. Concrete headwall on the WS end. [Additional Reference(s): DWR Levee Log, 2002, (HLM 8.33). USACE San Joaquin O&M Manual, Unit No. 601, Part No. 1, 1967, Amended in 1978, Revised 20 June 1985, (HLM 8.32). DWR As-Built Specification No. 65-30, Sheet No. 14, 27 April 1965, (HLM 8.32)].

WS view: Closeup of flapgate and outlet filled with sediment at toe.
