**Flood Control Project Maintenance
Levee Inspections**
LMA District Cover Sheet
Spring 2013 Levee Inspection Results

Lower San Joaquin Levee District

**Flood Control Project Maintenance
Levee Inspections**

Waterway			Bank	Unit Miles
Unit No. 01 San Joaquin River			Right	22.56
	Spring (March - May)	Summer (June - August)	(September - November) Fall	Winter (December - February)
Unit Maintenance Rating (Fall Only)				
Date of Inspection	06/04/2013 - 06/06/2013			
DWR Inspector	Richard Willoughby			
Accompanied By

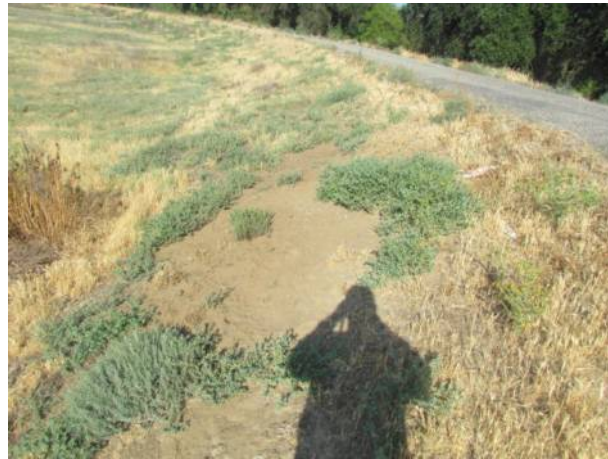
richard_s_20130610_149.JPG

Looking south at repaired site on landward slope.
(Spring 2013)

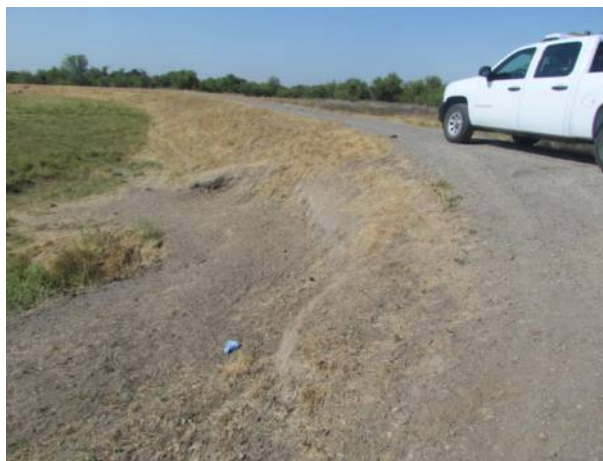
richard_s_20130610_150.JPG

Looking south at damage slope by livestock on landward slope.

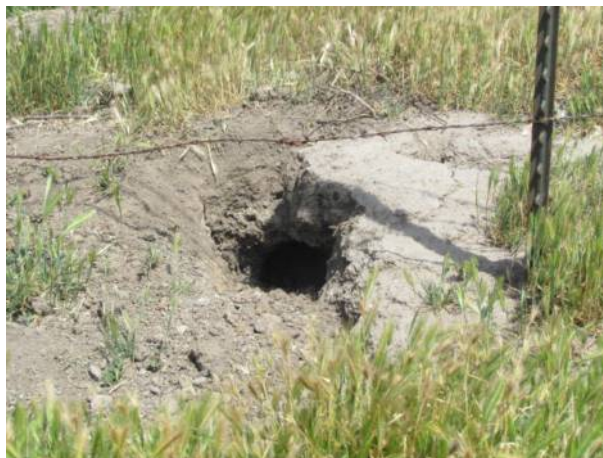
Levee Mile Report Line	17
Start Levee Mile	5.75
End Levee Mile	5.75
Location	Land Side
Category	
Item	Animal Control

Looking east at one of several rodent holes on landside shoulder and slope.

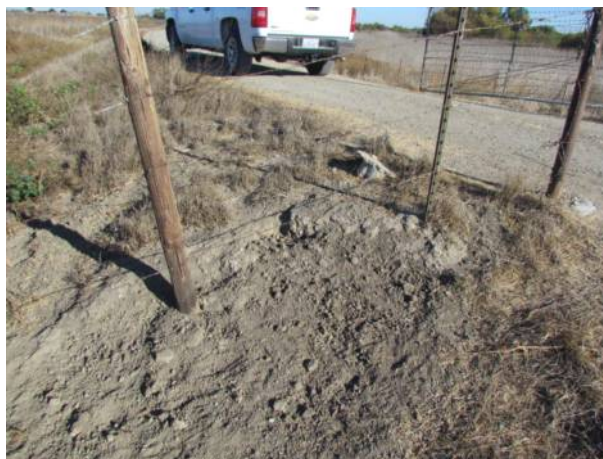
richard_s_20130304_070.JPG

Looking south at repaired rodent site on landside slope. (Fall 2012)

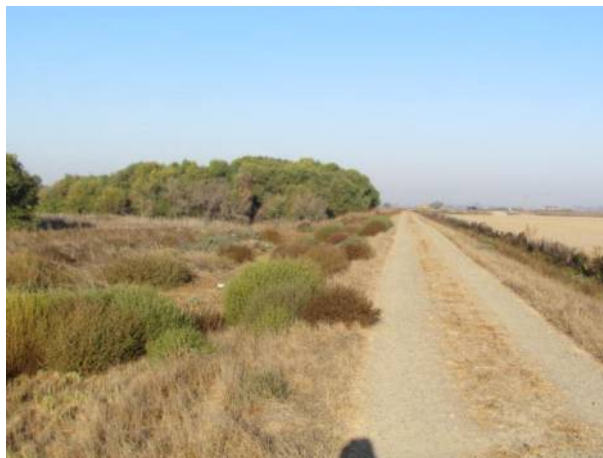
Levee Mile Report Line	24
Start Levee Mile	9.02
End Levee Mile	9.50
Location	Water Side
Category	
Item	Vegetation

Looking south at typical view of tumble weeds on landside and waterside slope.

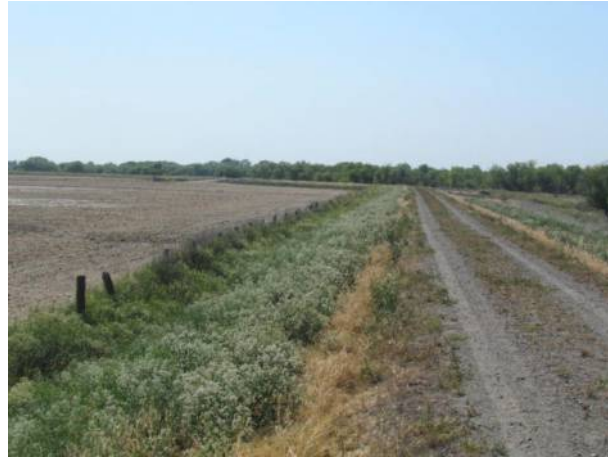
richard_s_20130610_152.JPG

Looking south at typical view of levee. (Spring 2013)

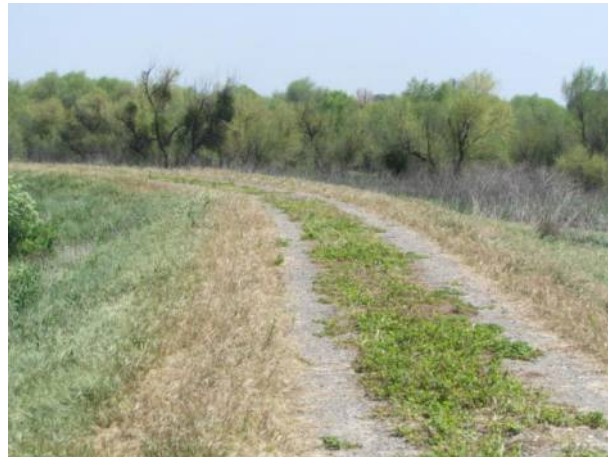
Levee Mile Report Line	26
Start Levee Mile	9.21
End Levee Mile	10.76
Location	Crown
Category	
Item	Crown Surface / Depressions / Rutting

Looking south at typical view of vegetation on levee crown.

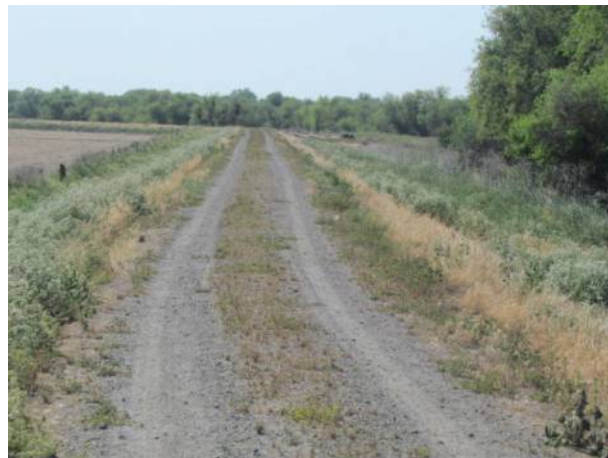
Levee Mile Report Line	26
Start Levee Mile	9.21
End Levee Mile	10.76
Location	Crown
Category	
Item	Crown Surface / Depressions / Rutting

Looking south at vegetation on levee crown. (Spring 2013)

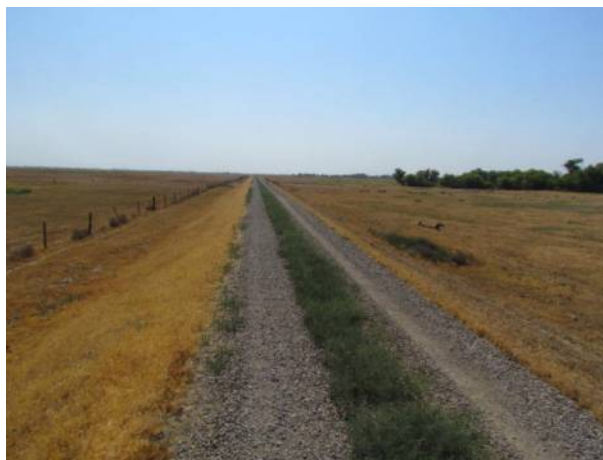
Levee Mile Report Line	27
Start Levee Mile	10.88
End Levee Mile	11.41
Location	Crown
Category	
Item	Crown Surface / Depressions / Rutting
Looking south at vegetation on levee crown.	
richard_s_20130610_153.JPG

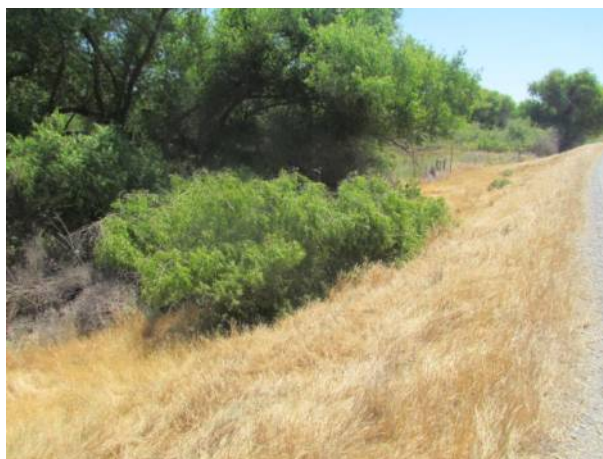
Levee Mile Report Line	29
Start Levee Mile	15.79
End Levee Mile	15.79
Location	Land Side
Category	
Item	Encroachments
Looking north at a downed tree limb on landward slope and toe.	
richard_s_20130611_199.JPG

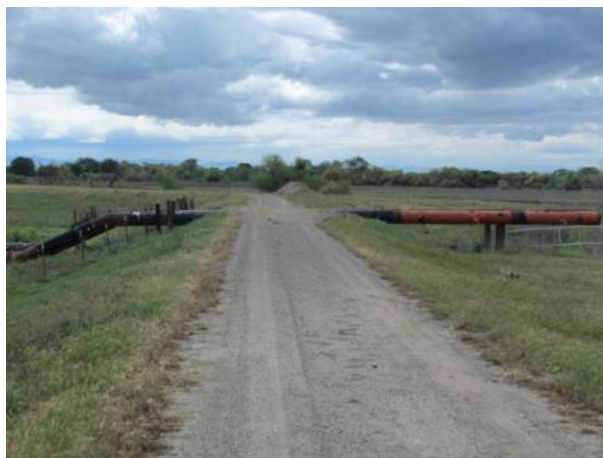
Levee Mile Report Line	32
Start Levee Mile	19.33
End Levee Mile	19.33
Location	Crown
Category	
Item	Encroachments
Looking south at pipe across levee crown.	
richard_s_20130304_061.jpg

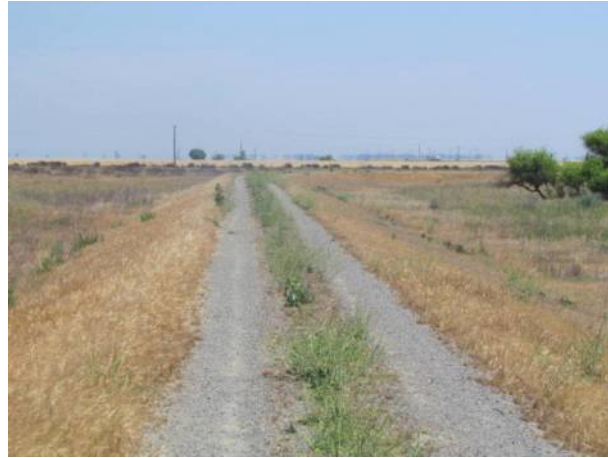
richard_s_20130611_204.JPG

Looking north at vegetation on levee crown,

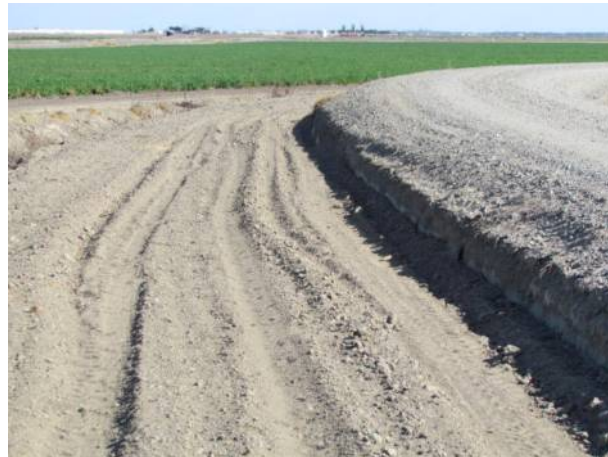
Levee Mile Report Line	34
Start Levee Mile	21.46
End Levee Mile	22.02
Location	Land Side
Category	
Item	Encroachments

Looking west at farmer discing landside slope.

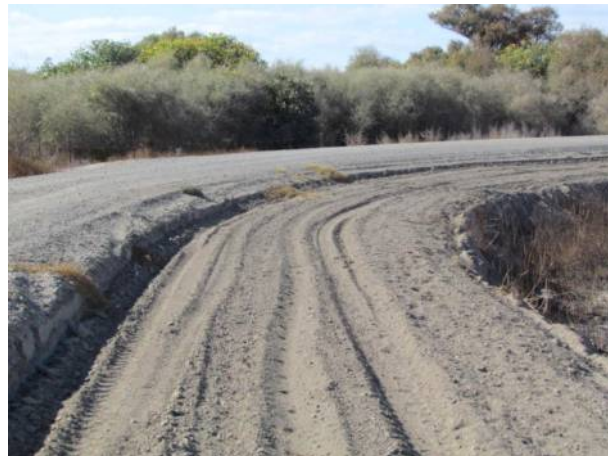
Levee Mile Report Line	34
Start Levee Mile	21.46
End Levee Mile	22.02
Location	Land Side
Category	
Item	Encroachments

Looking east at farmer discing into landside slope.

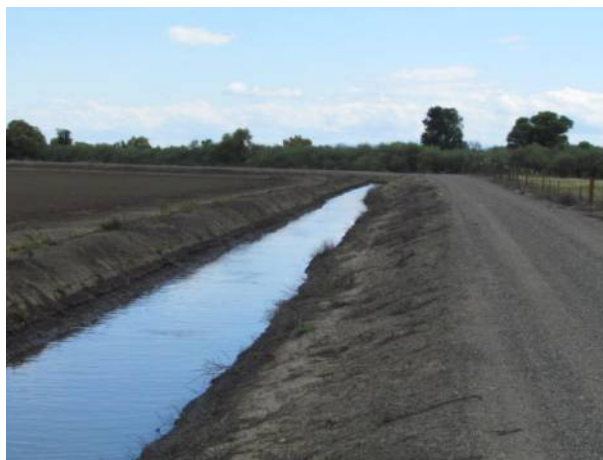
richard_s_20130304_065.jpg

Looking upstream at irrigation at landside toe.

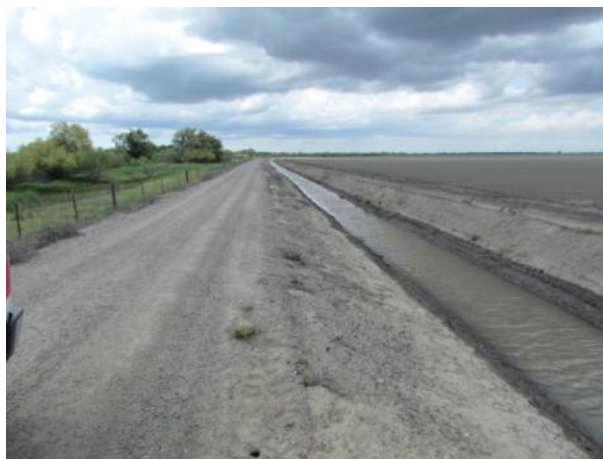
Levee Mile Report Line	35
Start Levee Mile	22.09
End Levee Mile	22.56
Location	Land Side
Category	
Item	Encroachments

Looking downstream at irrigation ditch at landside toe.

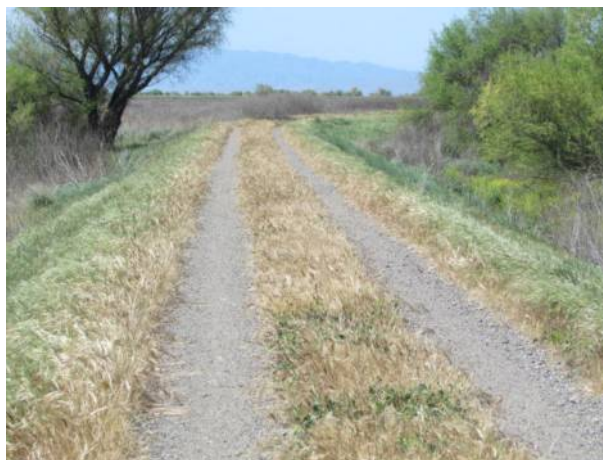
richard_s_20130304_074.jpg

Looking north at vegetation on levee crown.

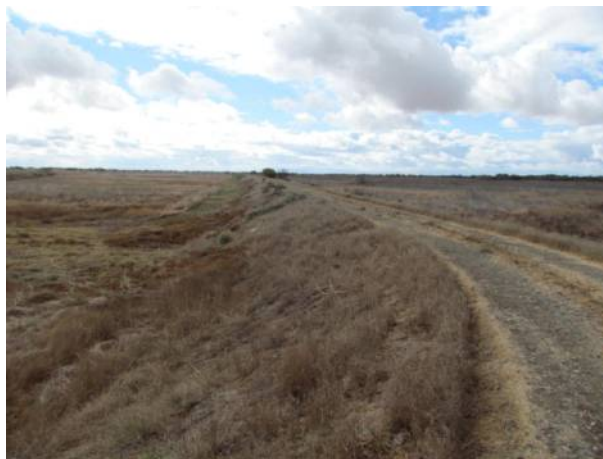
Levee Mile Report Line	2
Start Levee Mile	0.00
End Levee Mile	7.87
Location	Land Side
Category	
Item	Vegetation

Looking north at typical view of levee slopes.

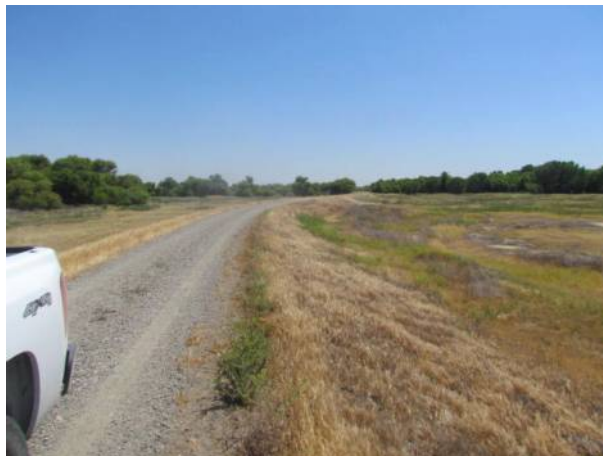
Levee Mile Report Line	2
Start Levee Mile	0.00
End Levee Mile	7.87
Location	Land Side
Category	
Item	Vegetation

Looking south at typical view of landward slope.
(Spring 2013)

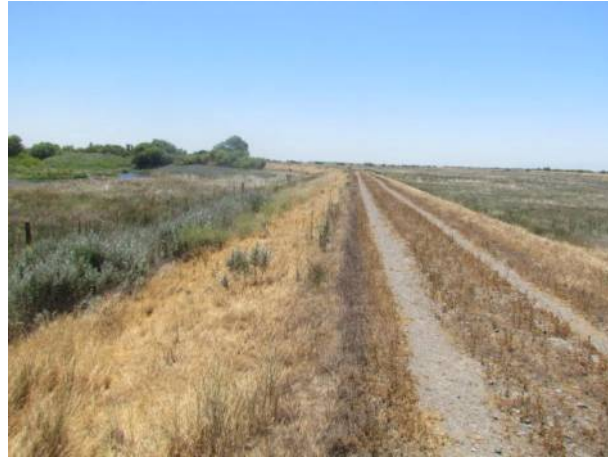
richard_s_20130611_209.JPG

Looking north at typical view of waterward slope.

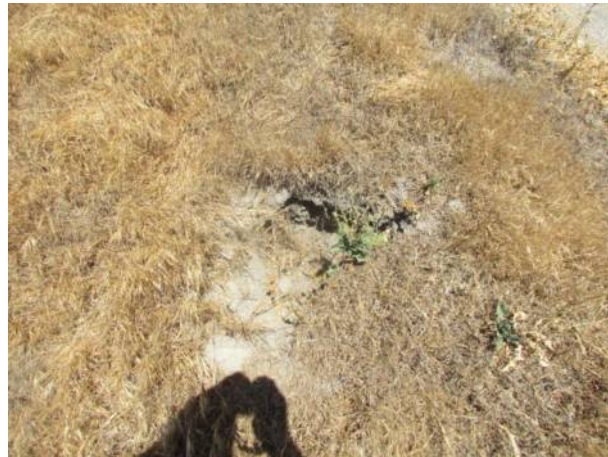
Levee Mile Report Line	4
Start Levee Mile	0.13
End Levee Mile	0.13
Location	Land Side
Category	
Item	Animal Control

Looking at large rodent hole on landward slope.

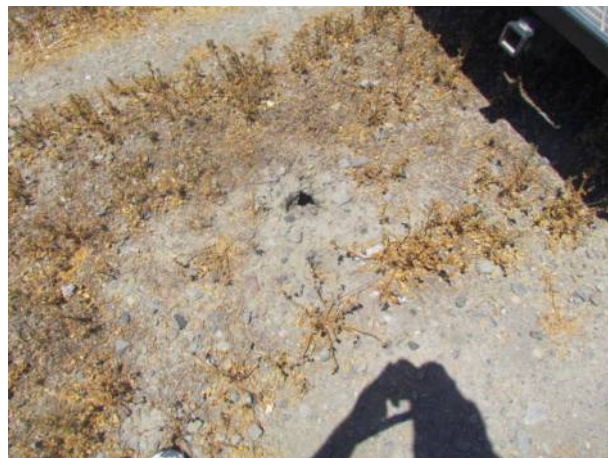
Levee Mile Report Line	5
Start Levee Mile	0.13
End Levee Mile	0.13
Location	Crown
Category	
Item	Animal Control

Looking at rodent hole on levee crown.

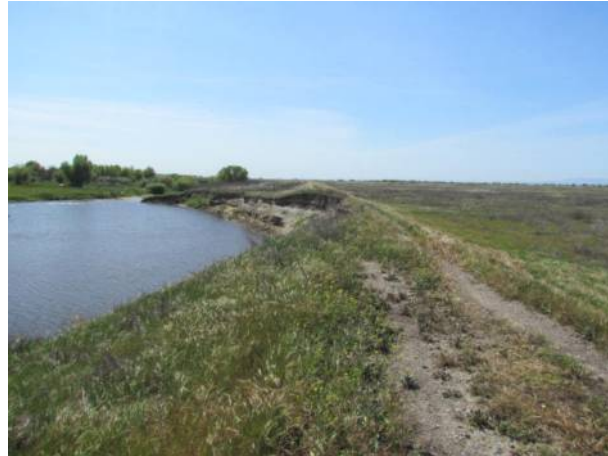
Levee Mile Report Line	6
Start Levee Mile	0.77
End Levee Mile	0.77
Location	Water Side
Category	
Item	Erosion / Bank Caving
Looking south at large erosion on waterside slope. (Spring 2012)	
richard_s_20130304_076.jpg

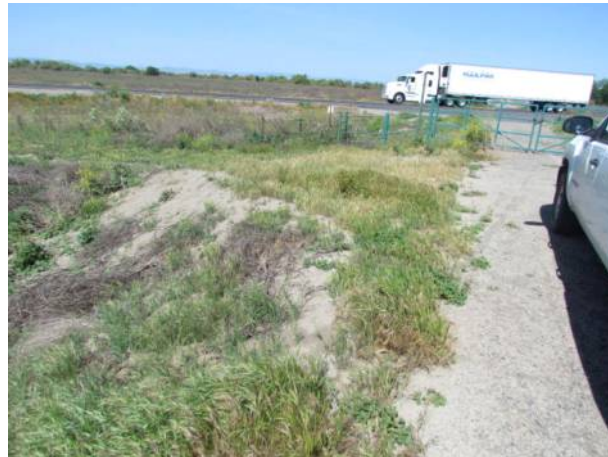
Levee Mile Report Line	7
Start Levee Mile	2.33
End Levee Mile	2.33
Location	Land Side
Category	
Item	Encroachments
Looking northwest at ramp on landside slope near Hwy 140.	
richard_s_20130304_072.jpg

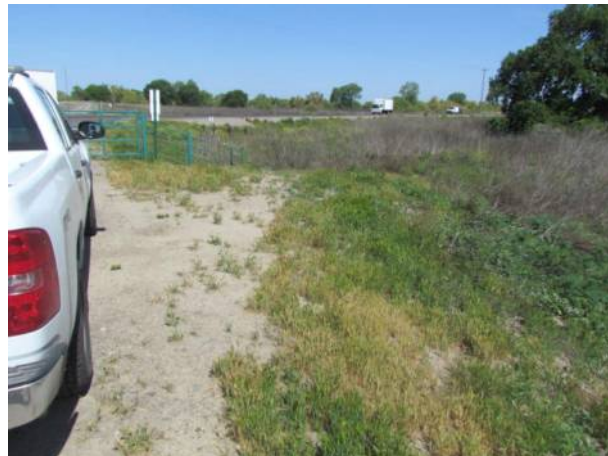
Levee Mile Report Line	7
Start Levee Mile	2.33
End Levee Mile	2.33
Location	Land Side
Category	
Item	Encroachments
Looking northeast at ramp on waterside slope near Hwy 140.	
richard_s_20130304_073.jpg

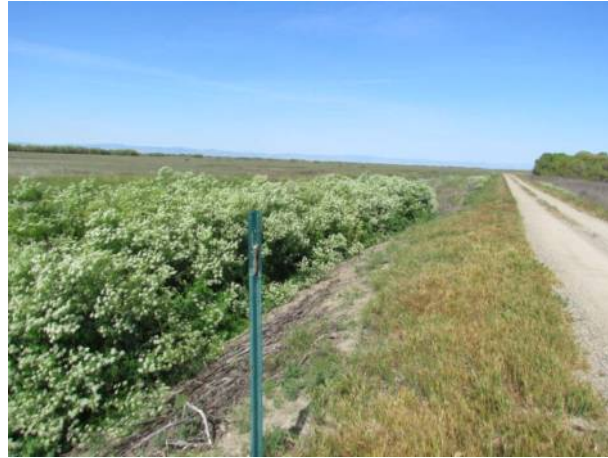
richard_s_20130304_077.jpg

Looking north dense vegetation at landside slope and toe.

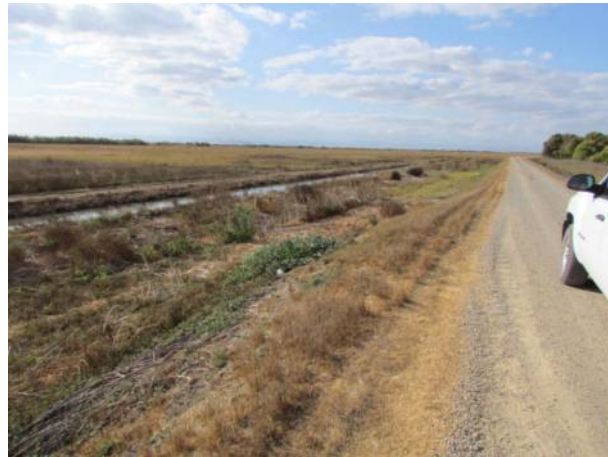
Levee Mile Report Line	9
Start Levee Mile	7.76
End Levee Mile	7.76
Location	Land Side
Category	
Item	Vegetation

Looking north at removed vegetation on landside berm. (Fall 2012)

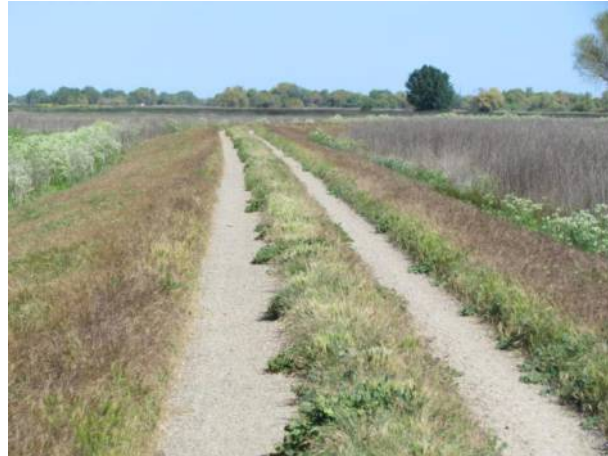
Levee Mile Report Line	1
Start Levee Mile	7.87
End Levee Mile	13.45
Location	Crown
Category	
Item	Crown Surface / Depressions / Rutting
Looking north at vegetation on levee crown.	
richard_s_20130304_080.jpg

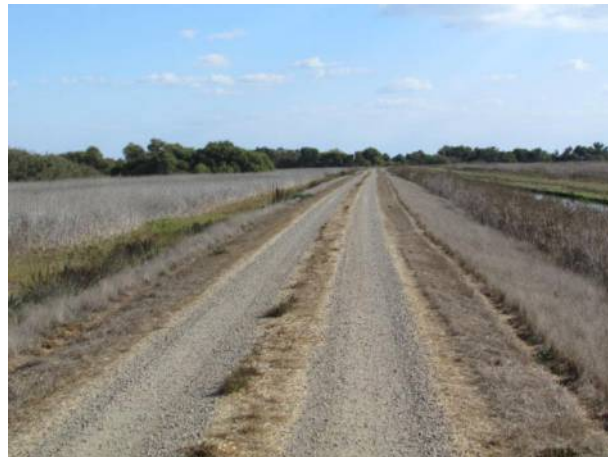
Levee Mile Report Line	1
Start Levee Mile	7.87
End Levee Mile	13.45
Location	Crown
Category	
Item	Crown Surface / Depressions / Rutting
Looking at typical view of levee crown.	
richard_s_20130304_081.JPG

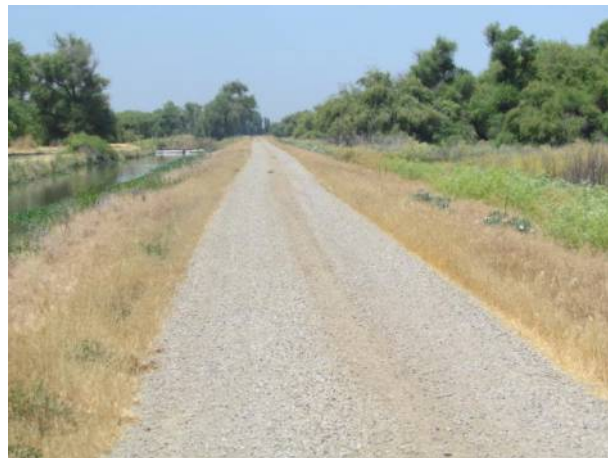
Levee Mile Report Line	1
Start Levee Mile	7.87
End Levee Mile	13.45
Location	Crown
Category	
Item	Crown Surface / Depressions / Rutting
Looking north at levee crown.	
richard_s_20130611_206.JPG

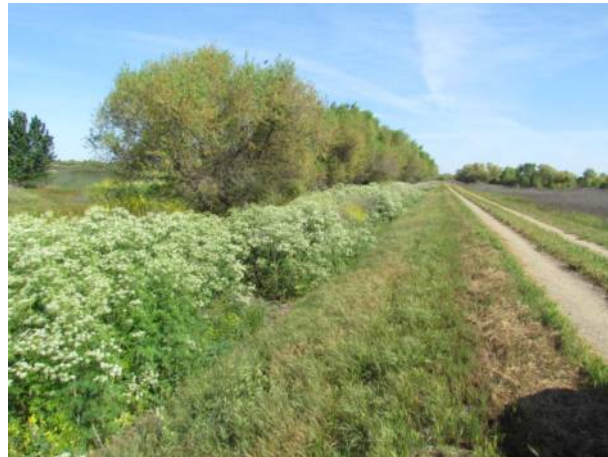
Levee Mile Report Line	5
Start Levee Mile	9.50
End Levee Mile	9.98
Location	Land Side
Category	
Item	Vegetation
Looking northwest at dense vegetation on landside slope and toe.	
richard_s_20130304_082.jpg

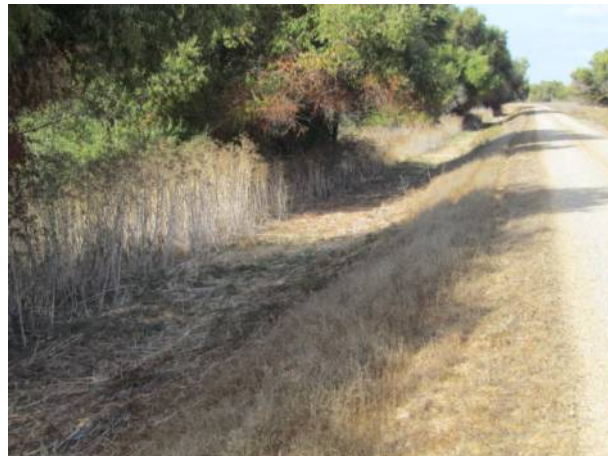
Levee Mile Report Line	5
Start Levee Mile	9.50
End Levee Mile	9.98
Location	Land Side
Category	
Item	Vegetation
Looking north at removed wild growth on landside toe. (Fall 2012)	
richard_s_20130304_083.JPG

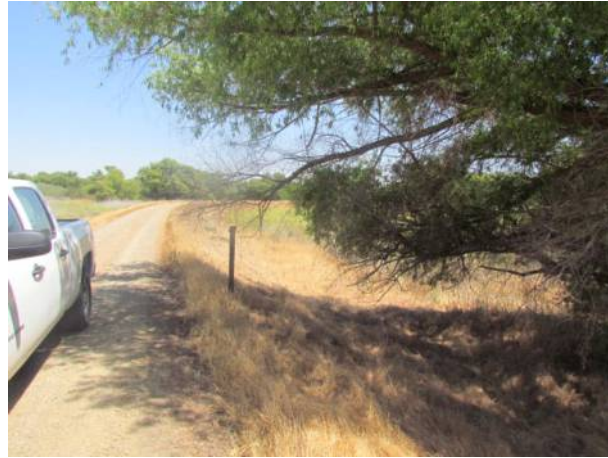
richard_s_20130611_207.JPG

Looking south at tree on landward toe.

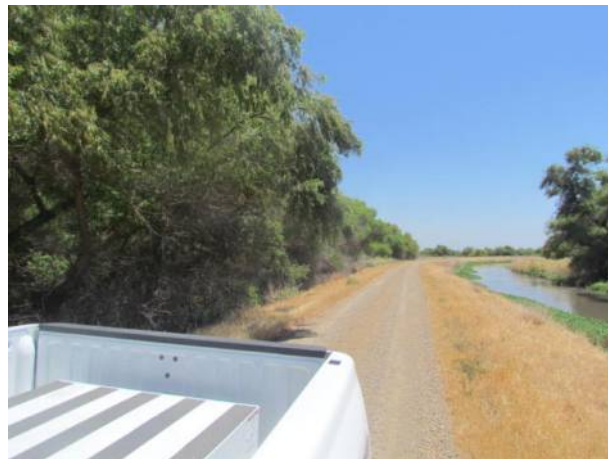
Levee Mile Report Line	9
Start Levee Mile	13.47
End Levee Mile	13.47
Location	Land Side
Category	
Item	Trim / Thin Trees

Looking south at overhanging tree limb on landward slope.

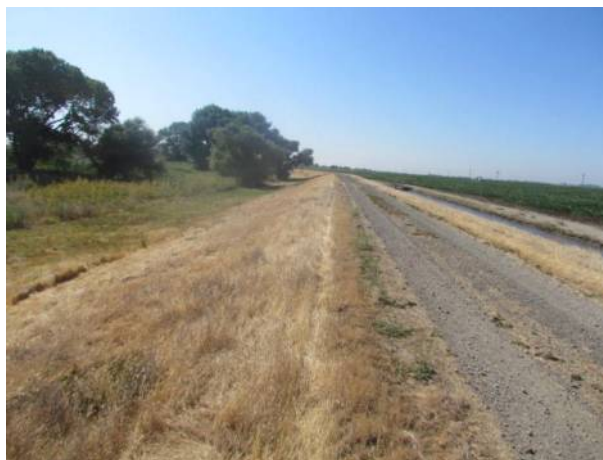
richard_s_20130611_193.JPG

Looking north at typical view of waterward slope.

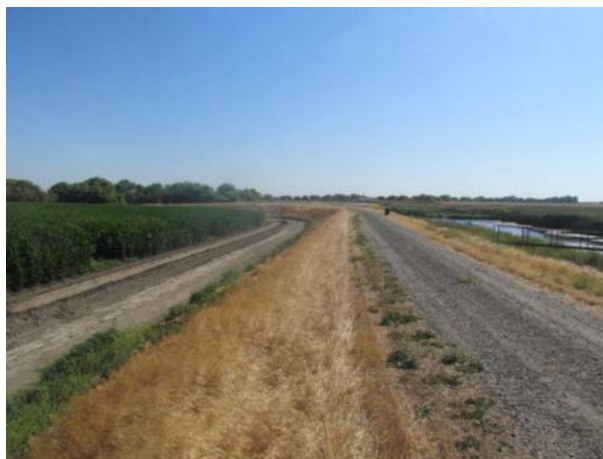
Levee Mile Report Line	2
Start Levee Mile	0.00
End Levee Mile	2.16
Location	Land Side
Category	
Item	Vegetation

Looking south at typical view of landward slope.

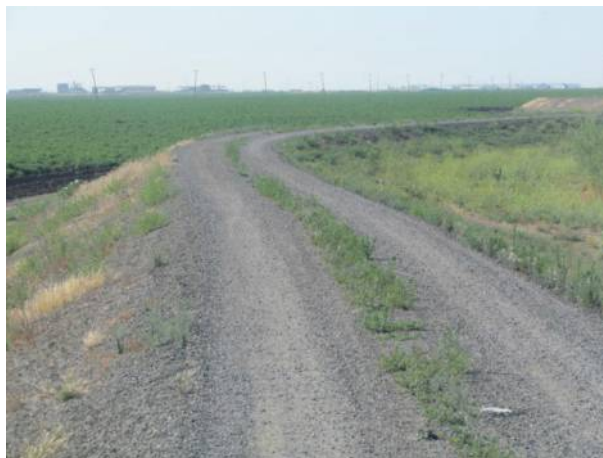
Levee Mile Report Line	5
Start Levee Mile	0.45
End Levee Mile	2.16
Location	Crown
Category	
Item	Vegetation

Looking south at levee crown.

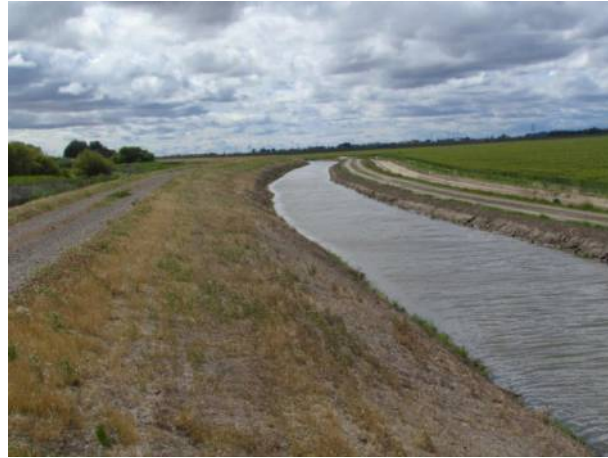
richard_s_20130304_085.jpg

Looking north at irrigation ditch at landside toe.

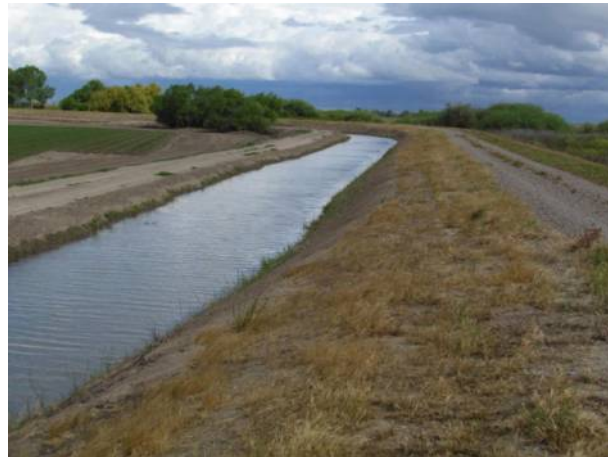
Levee Mile Report Line	3
Start Levee Mile	0.32
End Levee Mile	1.49
Location	Crown
Category	
Item	Encroachments

Looking north at irrigation ditch at landside toe.

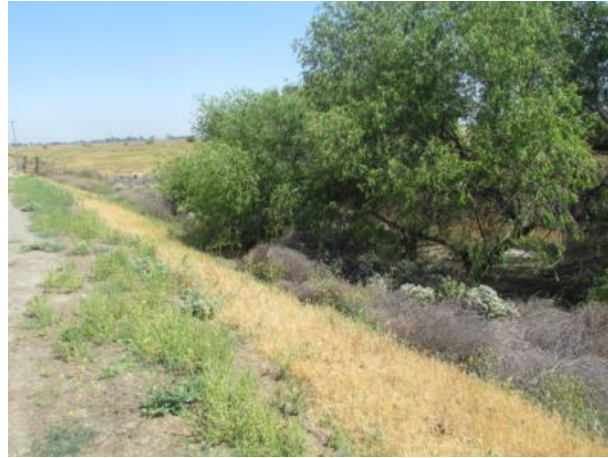
Looking east at untrimmed trees on landward toe.

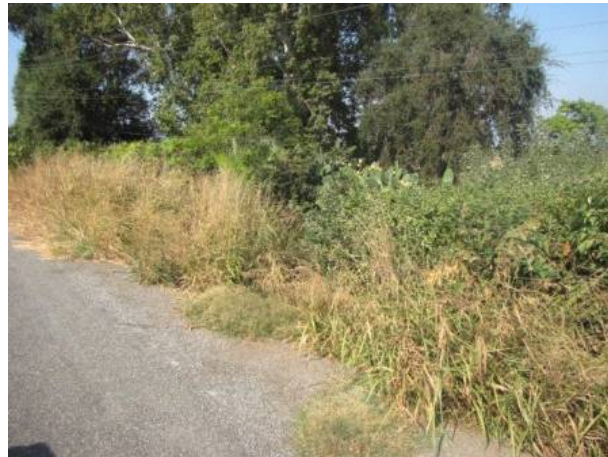
Levee Mile Report Line	6
Start Levee Mile	2.81
End Levee Mile	2.86
Location	Land Side
Category	
Item	Trim / Thin Trees

Looking south at dense trees on landside slope.

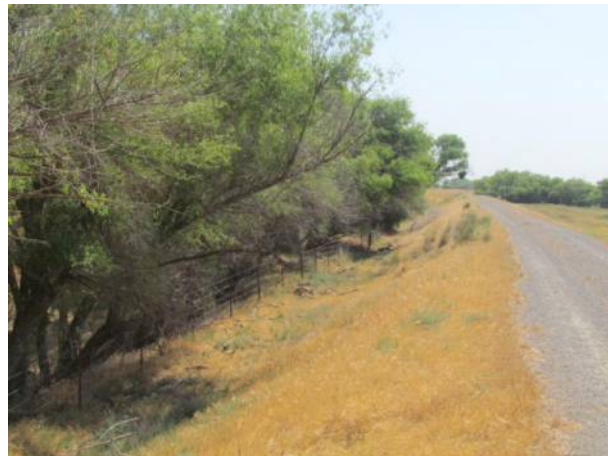
Levee Mile Report Line	6
Start Levee Mile	2.81
End Levee Mile	2.86
Location	Land Side
Category	
Item	Trim / Thin Trees

Looking south at trimmed trees on landward slope and toe.

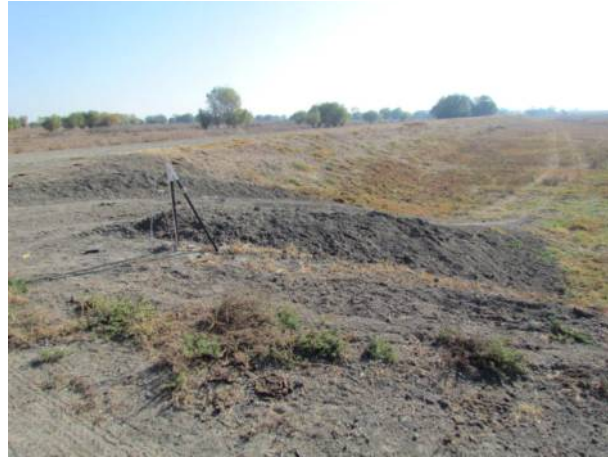
Looking south at unauthorized ramp on waterside slope.

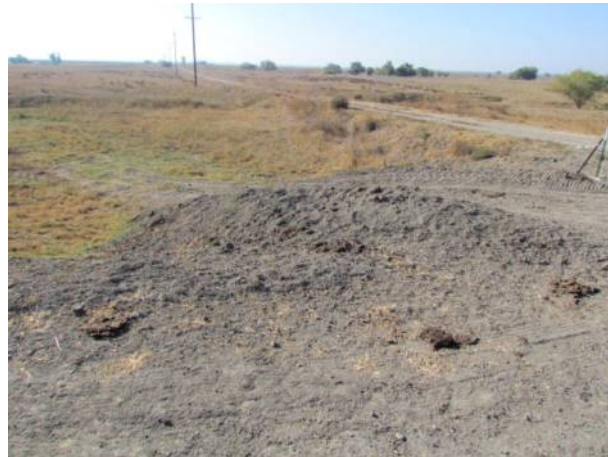
Levee Mile Report Line	7
Start Levee Mile	3.19
End Levee Mile	3.19
Location	Water Side
Category	
Item	Encroachments

Looking northwest at unauthorized ramp on waterside slope.

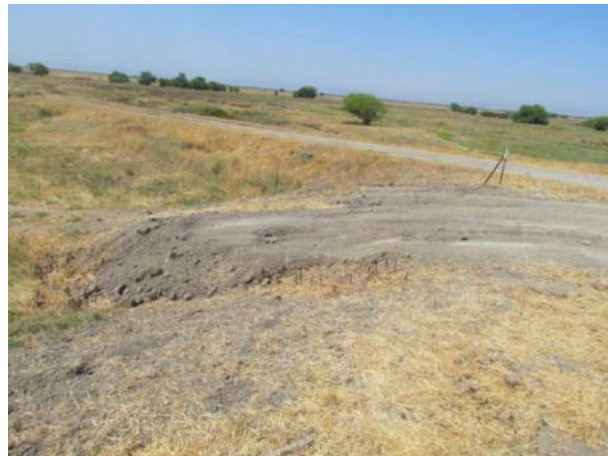
Levee Mile Report Line	7
Start Levee Mile	3.19
End Levee Mile	3.19
Location	Water Side
Category	
Item	Encroachments

Looking northwest at unauthorized ramp on waterward slope.

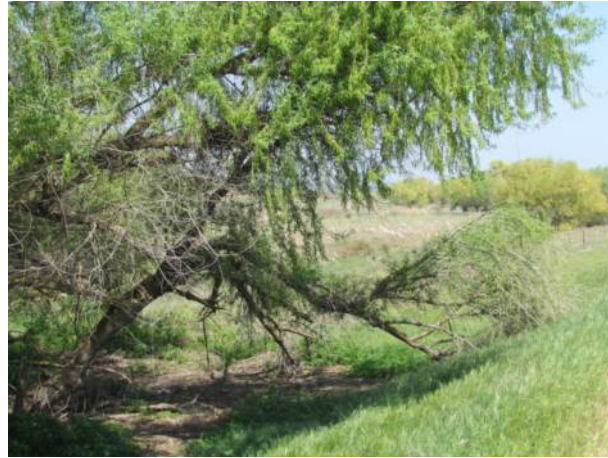
Levee Mile Report Line	9
Start Levee Mile	3.54
End Levee Mile	3.54
Location	Land Side
Category	
Item	Encroachments
Looking south at down tree limb on landside slope and toe.	
richard_s_20130304_087.jpg

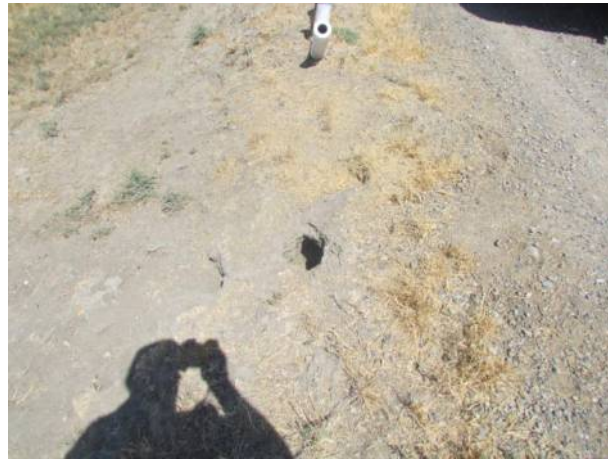
Levee Mile Report Line	5
Start Levee Mile	2.25
End Levee Mile	2.25
Location	Land Side
Category	
Item	Animal Control

Looking north at rodent hole on landward slope.

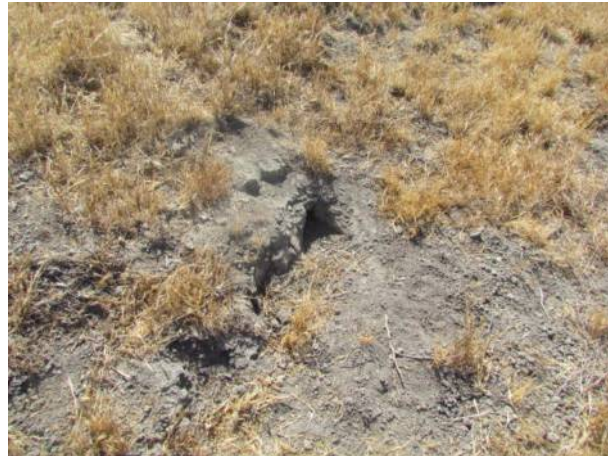
Levee Mile Report Line	7
Start Levee Mile	4.72
End Levee Mile	4.72
Location	Land Side
Category	
Item	Animal Control

Looking at typical rodent holes on landward slope.

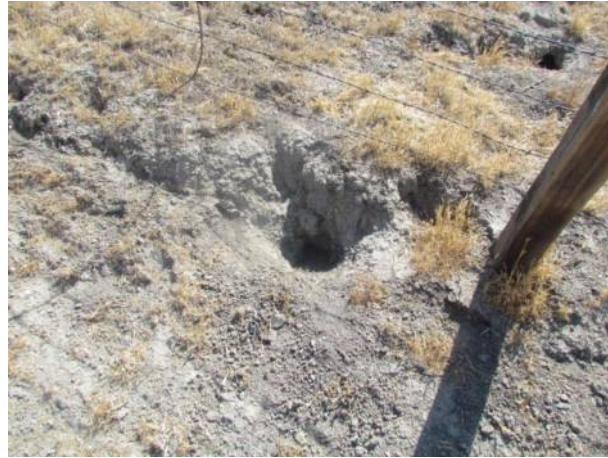
Looking at rodent hole along fence line on landward slope.

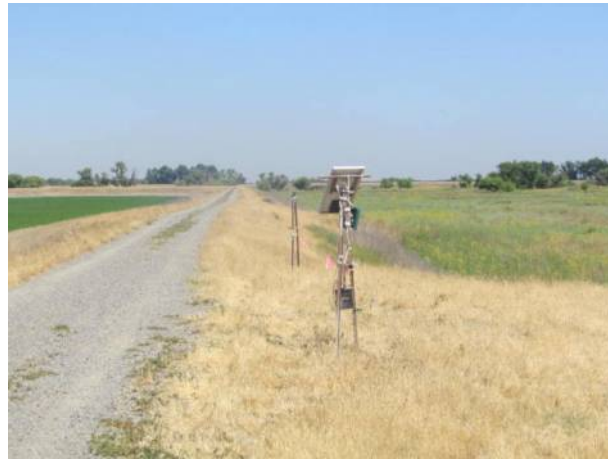
Levee Mile Report Line	13
Start Levee Mile	13.56
End Levee Mile	14.45
Location	Water Side
Category	
Item	Encroachments

Looking north at electrical fence on waterward shoulder.

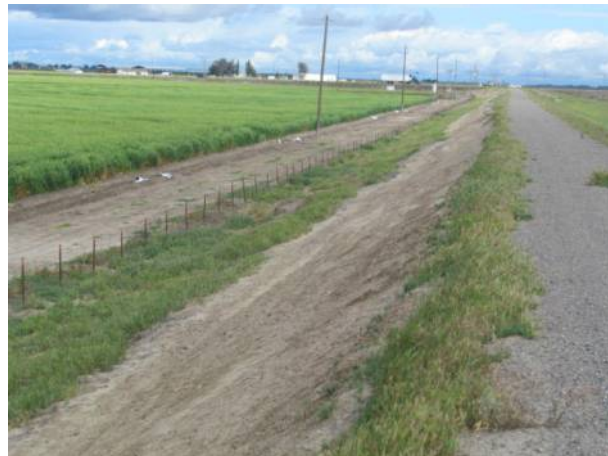
Levee Mile Report Line	17
Start Levee Mile	24.50
End Levee Mile	24.93
Location	Land Side
Category	
Item	Slope Stability

Looking north at livestock erosion on landside slope.

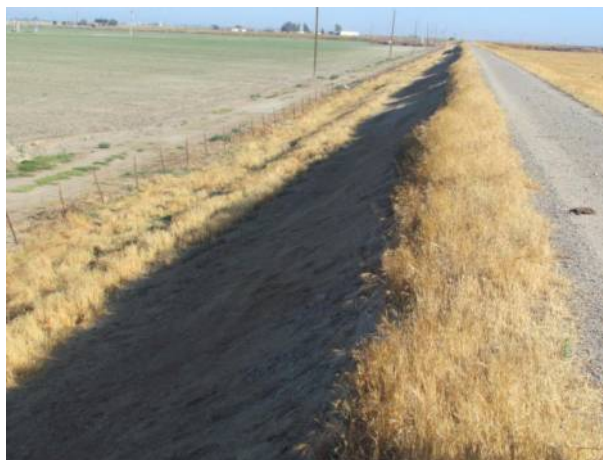
Looking north at livestock erosion on landward slope.

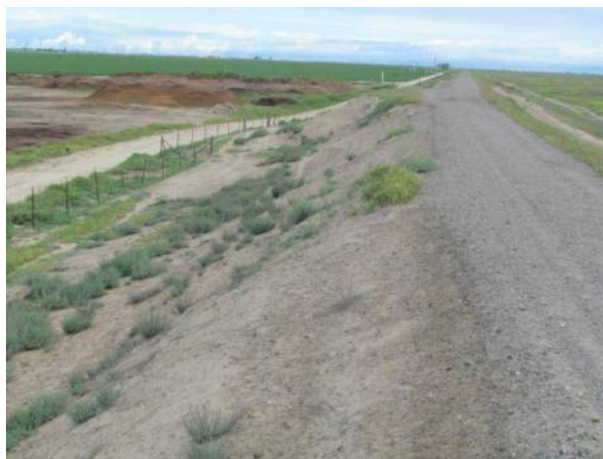
Levee Mile Report Line	18
Start Levee Mile	27.56
End Levee Mile	27.87
Location	Land Side
Category	
Item	Slope Stability

Looking north at livestock erosion on landside shoulder and slope.

DWR ID: DWR_NA0010_06_s_2012_5									
18	27.56	27.87		Slope Stability	LS M Ma	S2 : Repair the levee slope damaged by foot traffic and prevent access where possible. Inspector Comments: Landside erosion caused by livestock.	37.036955 ° -120.484395 °	37.032887 ° -120.481225 °	3 Y
DWR ID: DWR_NA0010_06_s_2012_3									
19	28.62	28.62		Animal Control	LS M Ma	A3 : No rodents visible, but rodent burrows visible; need to backfill and compact or grout burrows.	37.030102 ° -120.469122 °	37.030102 ° -120.469122 °	19
DWR ID: DWR_NA0010_06_s_2012_19									
20	30.41	30.41		Encroachments	CR C En	PI : Pipe Inspector Comments: Landowner removed pipe.	37.025537 ° -120.440254 °	37.025537 ° -120.440254 °	11
DWR ID: DWR_NA0010_06_f_2012_11									
21	31.01	31.01		Animal Control	LS M Ma	A1 : Exterminate rodents and backfill and compact or grout burrows.	37.017955 ° -120.435017 °	37.017955 ° -120.435017 °	2 Y
DWR ID: DWR_NA0010_06_s_2012_2

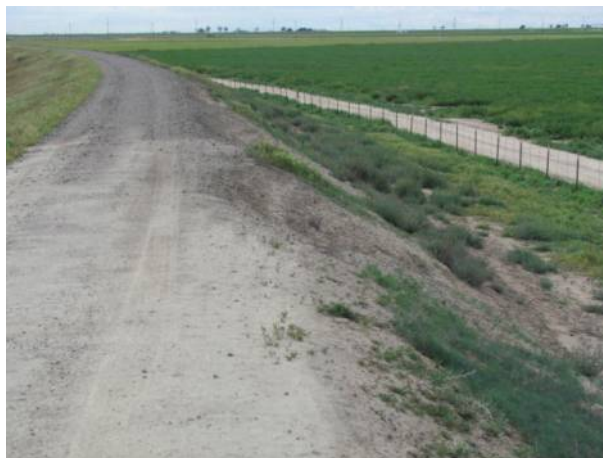
Levee Mile Report Line	18
Start Levee Mile	27.56
End Levee Mile	27.87
Location	Land Side
Category	
Item	Slope Stability

Looking south at livestock erosion on landside shoulder and slope.

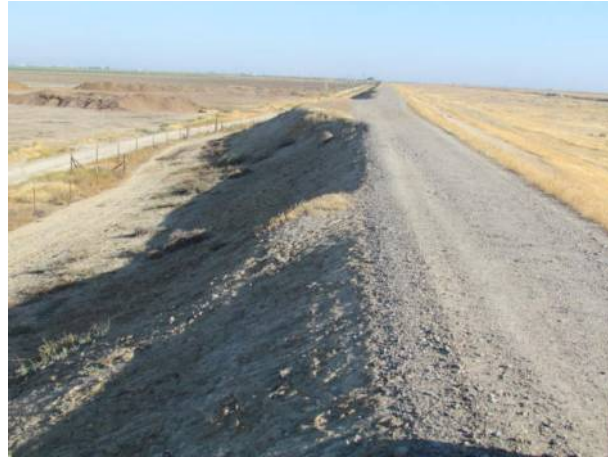
Levee Mile Report Line	18
Start Levee Mile	27.56
End Levee Mile	27.87
Location	Land Side
Category	
Item	Slope Stability
Looking north at livestock erosion on landward slope. (Spring 2013)	
richard_s_20130611_188.JPG

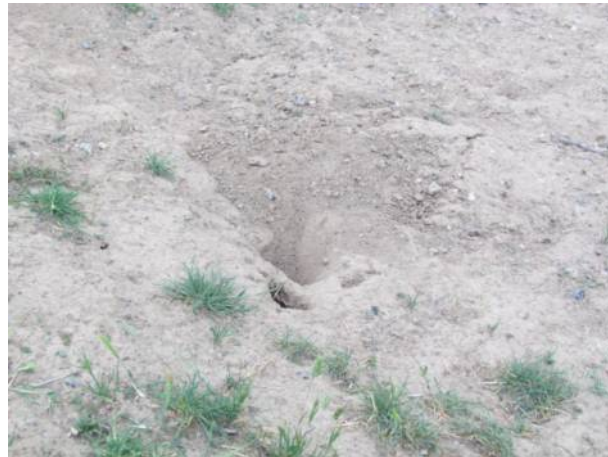
Levee Mile Report Line	21
Start Levee Mile	31.01
End Levee Mile	31.01
Location	Land Side
Category	
Item	Animal Control
Looking at typical rodent hole on landside slope.	
richard_s_20130304_096.jpg

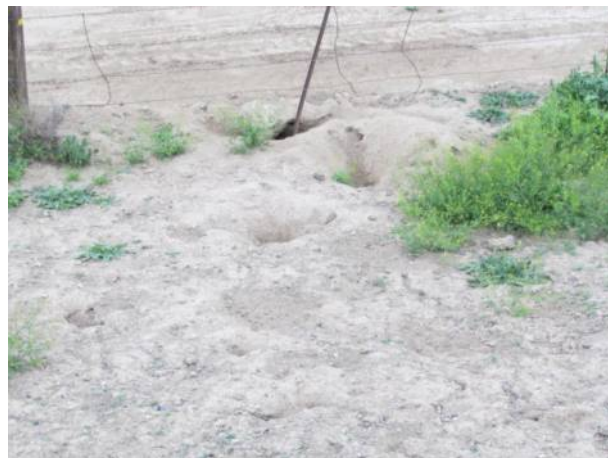
Levee Mile Report Line	21
Start Levee Mile	31.01
End Levee Mile	31.01
Location	Land Side
Category	
Item	Animal Control
Looking west at rodent holes on landside slope and toe near fence line.	
richard_s_20130304_097.jpg

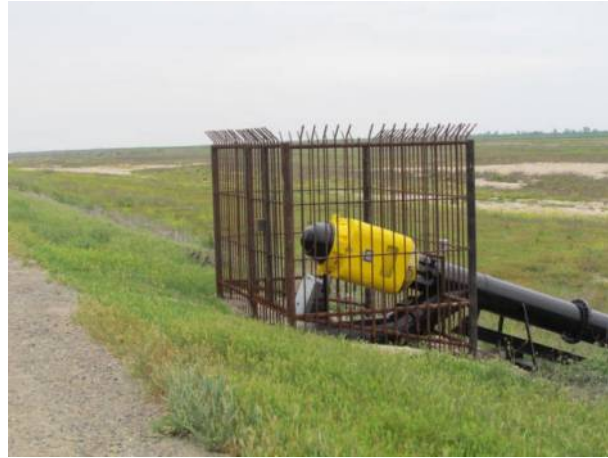
Levee Mile Report Line	22
Start Levee Mile	32.99
End Levee Mile	32.99
Location	Water Side
Category	
Item	Encroachments
Looking northeast at new metal fence around slant pump on waterside slope.	
richard_s_20130304_104.jpg

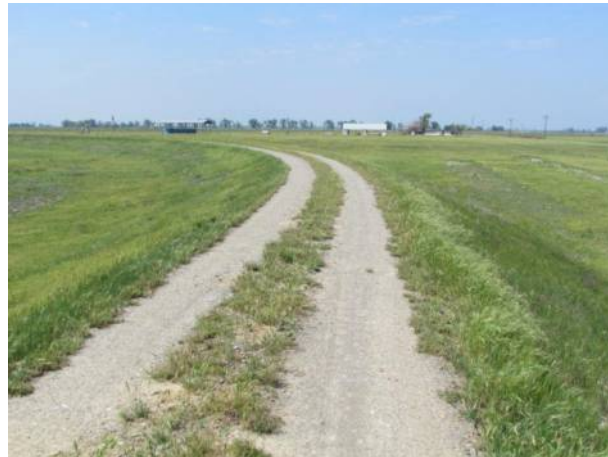
Levee Mile Report Line	3
Start Levee Mile	0.11
End Levee Mile	2.57
Location	Crown
Category	
Item	Crown Surface / Depressions / Rutting

Looking east at vegetation on levee crown.

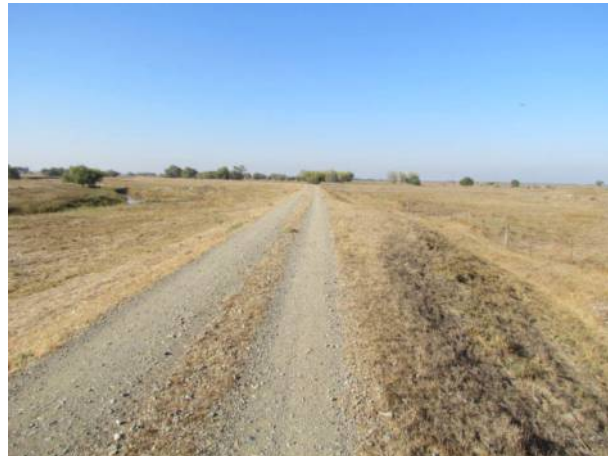
Levee Mile Report Line	3
Start Levee Mile	0.11
End Levee Mile	2.57
Location	Crown
Category	
Item	Crown Surface / Depressions / Rutting

Looking east at un-regraded levee crown. (Fall 2012)

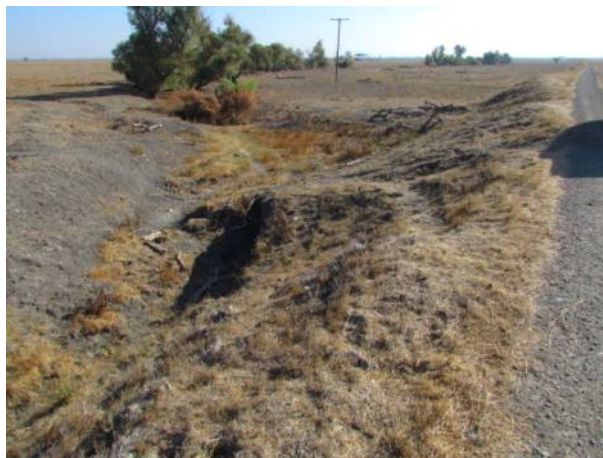
Looking southeast at landside slope and toe damage by livestock.

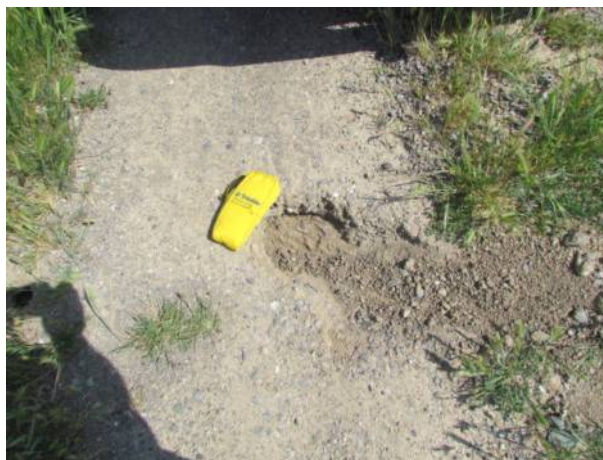
Looking at rodent hole on levee crown.

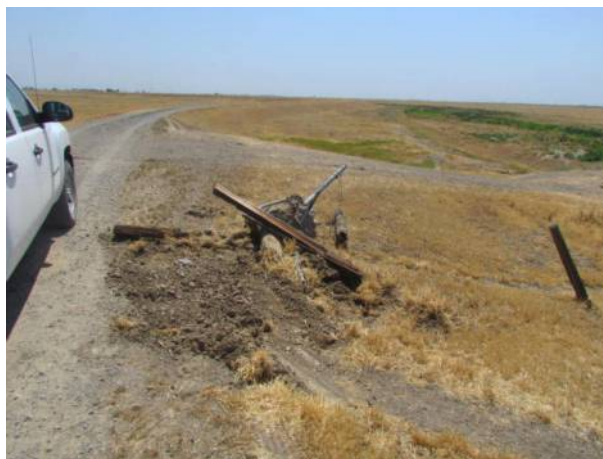
Levee Mile Report Line	9
Start Levee Mile	2.77
End Levee Mile	2.77
Location	Water Side
Category	
Item	Encroachments

Looking south at old fence poles on waterward slope.

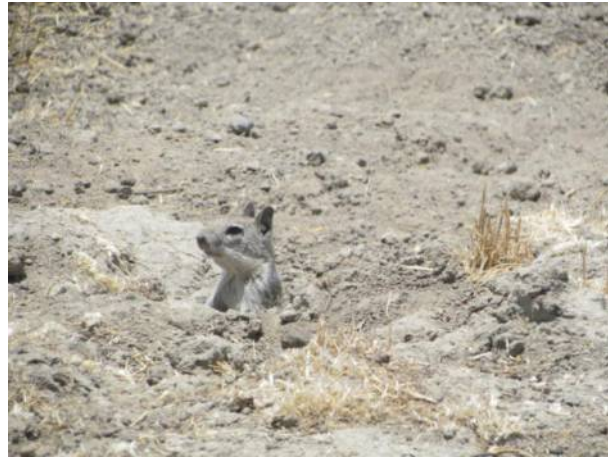
Levee Mile Report Line	5
Start Levee Mile	1.38
End Levee Mile	1.38
Location	Land Side
Category	
Item	Animal Control
Looking west at rodent holes on landward slope.	
richard_s_20130610_163.JPG

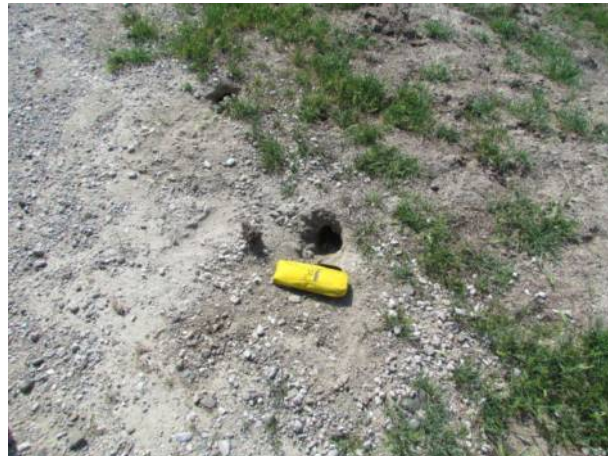
Levee Mile Report Line	7
Start Levee Mile	2.07
End Levee Mile	2.12
Location	Land Side
Category	
Item	Animal Control
Looking at typical rodent hole along the section.	
richard_s_20130304_112.jpg

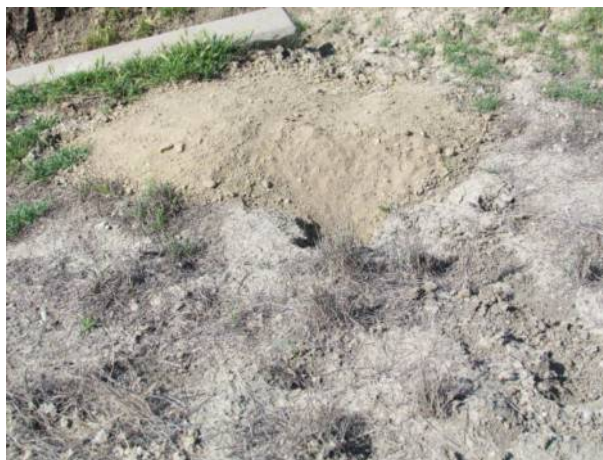
Looking at typical rodent hole on landside slope near headwall.

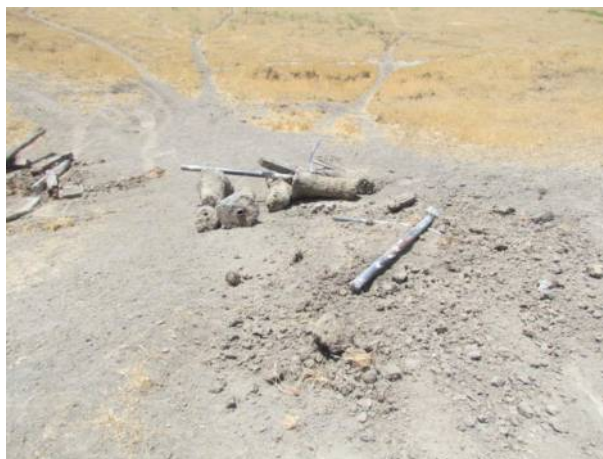
Levee Mile Report Line	8
Start Levee Mile	2.74
End Levee Mile	2.74
Location	Land Side
Category	
Item	Encroachments

Looking west at old fence poles on landward slope and toe.

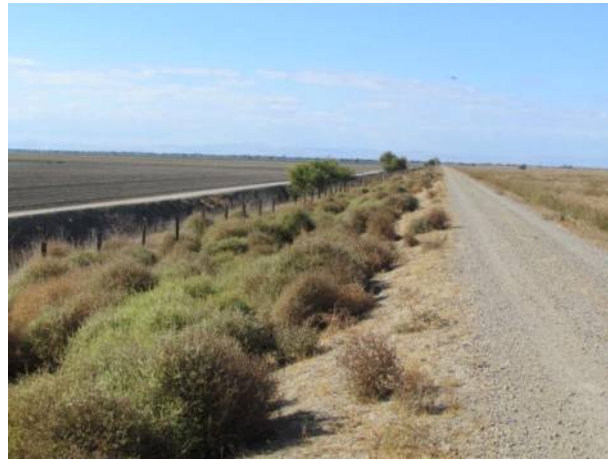
Looking at dense tumble weeds on landside and waterside slopes.

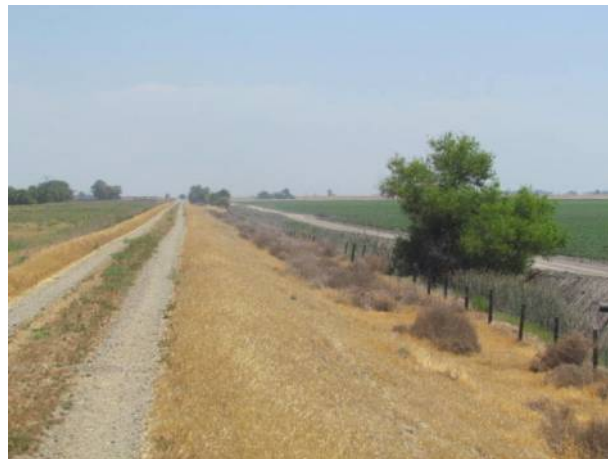
richard_s_20130611_203.JPG

Looking west at typical view of landward slope.

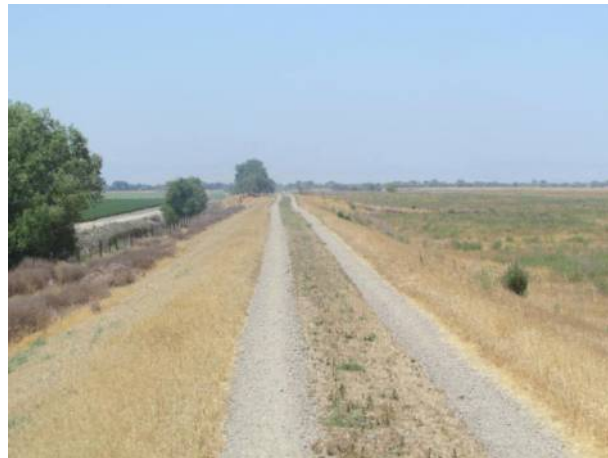
richard_s_20130611_202.JPG

Levee Mile Report Line	3
Start Levee Mile	0.00
End Levee Mile	2.43
Location	Crown
Category	
Item	Crown Surface / Depressions / Rutting

Looking west at vegetation on levee crown.
