**Flood Control Project Maintenance
Levee Inspections**
LMA District Cover Sheet
Spring 2013 Levee Inspection Results

Lower San Joaquin Levee District

**Flood Control Project Maintenance
Levee Inspections**

Waterway			Bank	Unit Miles
Unit No. 01 San Joaquin River			Right	22.56
	Spring (March - May)	Summer (June - August)	(September - November) Fall	Winter (December - February)
Unit Maintenance Rating (Fall Only)				
Date of Inspection	06/04/2013 - 06/06/2013			
DWR Inspector	Richard Willoughby			
Accompanied By

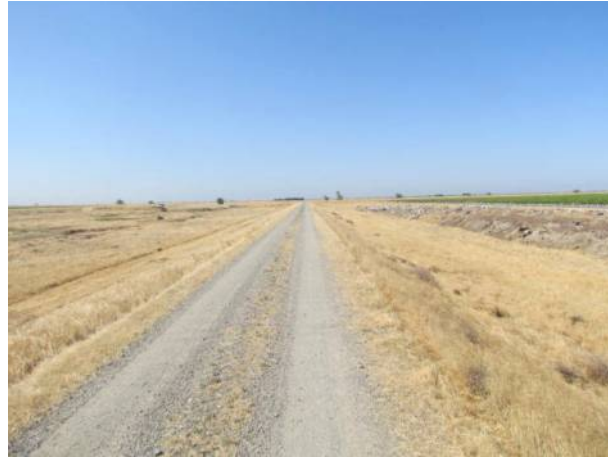
richard_s_20130610_169.JPG

Looking east at typical view of levee.

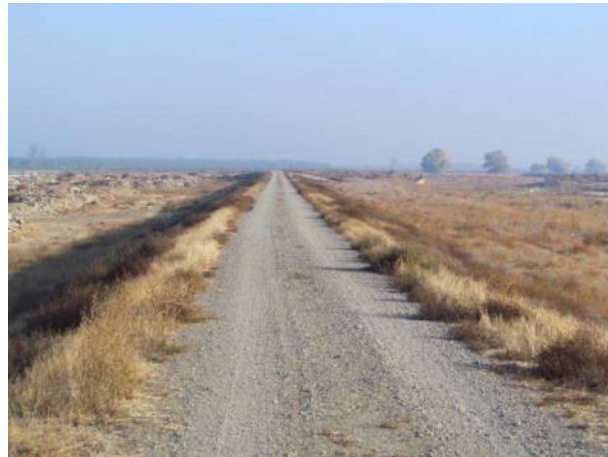
richard_s_20130304_119.JPG

Levee Mile Report Line	3
Start Levee Mile	0.02
End Levee Mile	1.26
Location	Water Side
Category	
Item	Vegetation

Looking east at typical view of landside and waterside slopes.

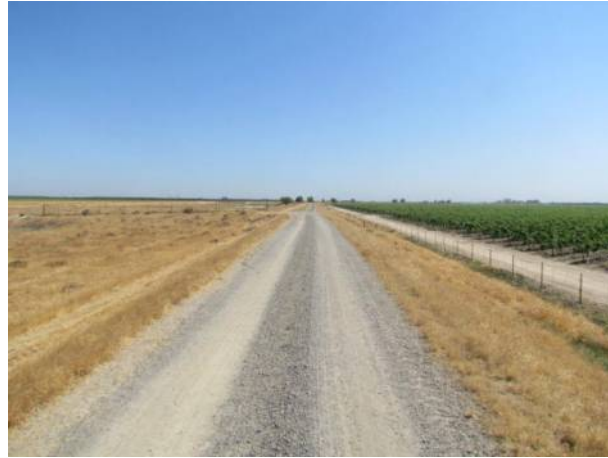
richard_s_20130610_170.JPG

Looking north at typical view of levee.

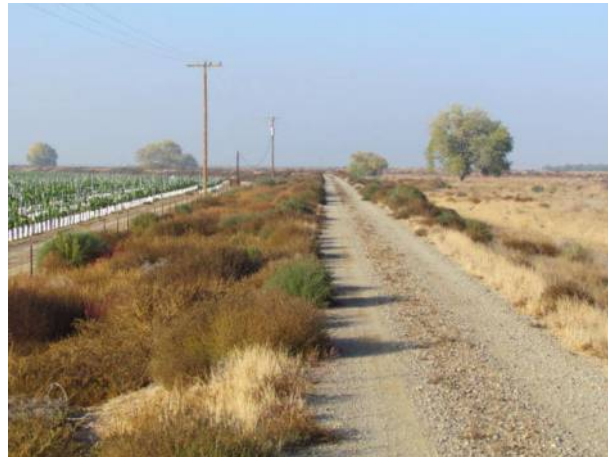
richard_s_20130304_120.JPG

Levee Mile Report Line	2
Start Levee Mile	0.00
End Levee Mile	1.25
Location	Water Side
Category	
Item	Vegetation

Looking west at typical view of tumble weeds on levee slopes.

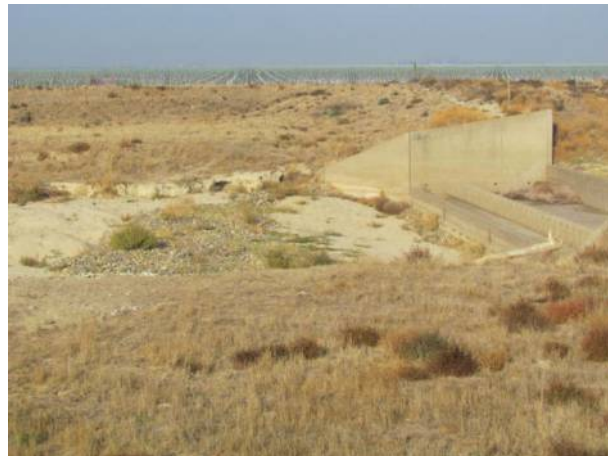
richard_s_20130304_121.JPG

Levee Mile Report Line	4
Start Levee Mile	0.08
End Levee Mile	0.08
Location	Water Side
Category	Channels
Item	Concrete Foundations

Looking south at erosion in channel near drop structure.

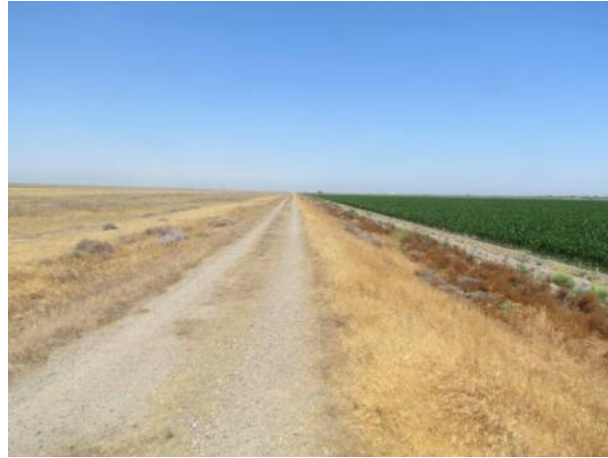
richard_s_20130610_171.JPG

Looking east at typical view of levee.

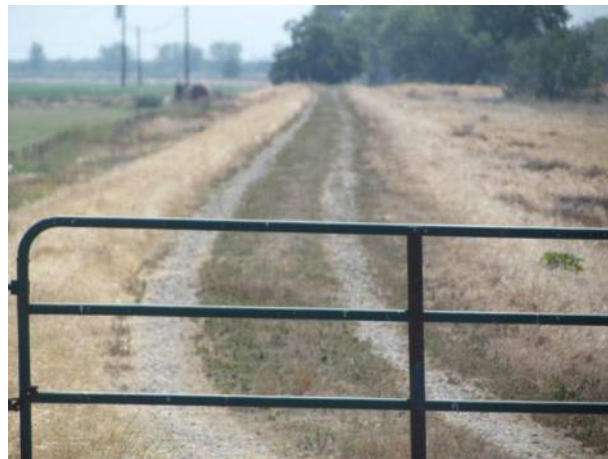
richard_s_20130610_172.JPG

Levee Mile Report Line	2
Start Levee Mile	0.00
End Levee Mile	1.99
Location	Crown
Category	
Item	Crown Surface / Depressions / Rutting

Looking east at vegetation on levee crown.
(Spring 2013)

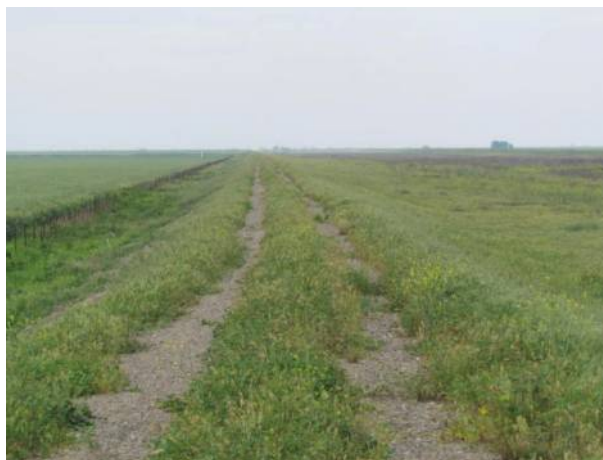
Levee Mile Report Line	1
Start Levee Mile	0.00
End Levee Mile	1.42
Location	Crown
Category	
Item	Crown Surface / Depressions / Rutting
Looking west (downstream) at unwanted vegetation on levee crown.	
richard_s_20130304_127.jpg

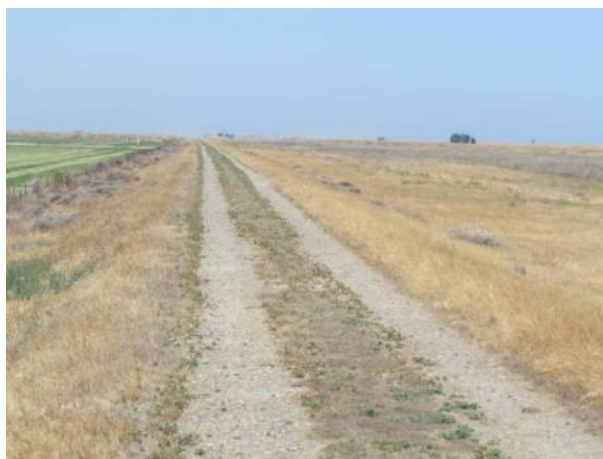
Levee Mile Report Line	1
Start Levee Mile	0.00
End Levee Mile	1.42
Location	Crown
Category	
Item	Crown Surface / Depressions / Rutting
Looking west at vegetation on levee crown.	
richard_s_20130610_173.JPG

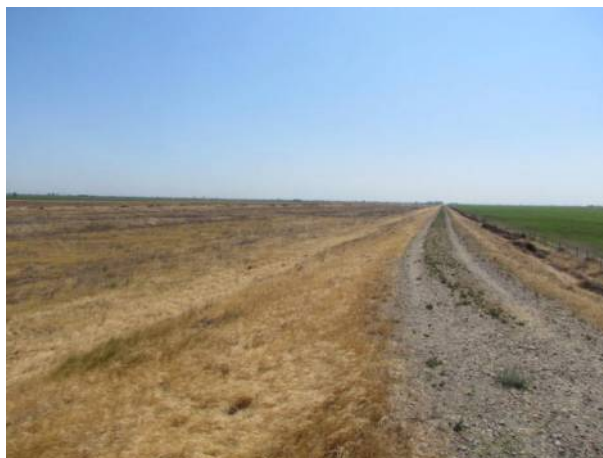
Levee Mile Report Line	2
Start Levee Mile	0.00
End Levee Mile	1.97
Location	Water Side
Category	
Item	Vegetation
Looking east at typical view of waterward slope.	
richard_s_20130610_175.JPG

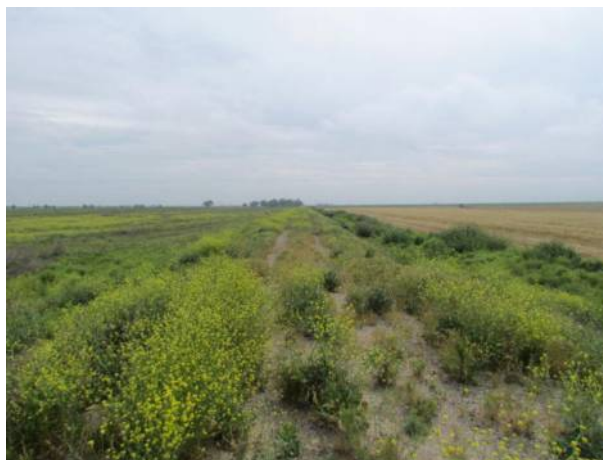
richard_s_20130304_125.jpg

Looking east (upstream) at unwanted vegetation on both levee slope and levee crown.

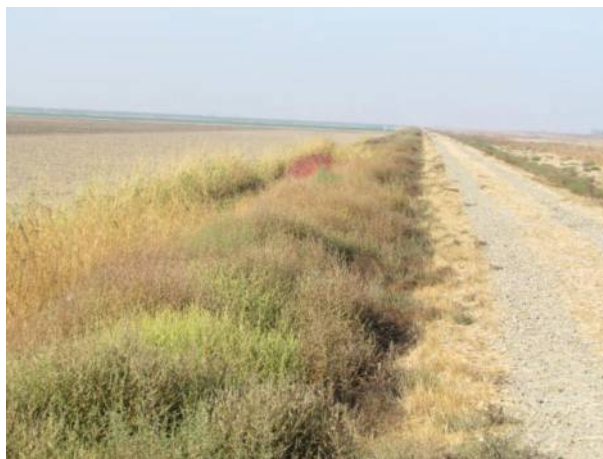
richard_s_20130304_126.JPG

Levee Mile Report Line	3
Start Levee Mile	0.00
End Levee Mile	1.97
Location	Land Side
Category	
Item	Vegetation

Looking west at typical view dense vegetation on waterside and landside slopes.

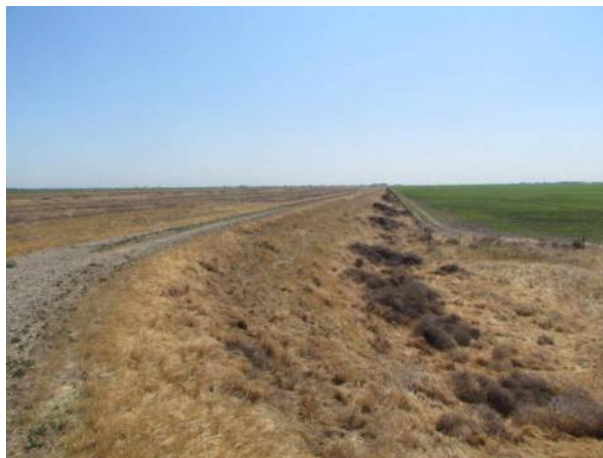
richard_s_20130610_174.JPG

Levee Mile Report Line	3
Start Levee Mile	0.00
End Levee Mile	1.97
Location	Land Side
Category	
Item	Vegetation

Looking east at typical view of landward slope.

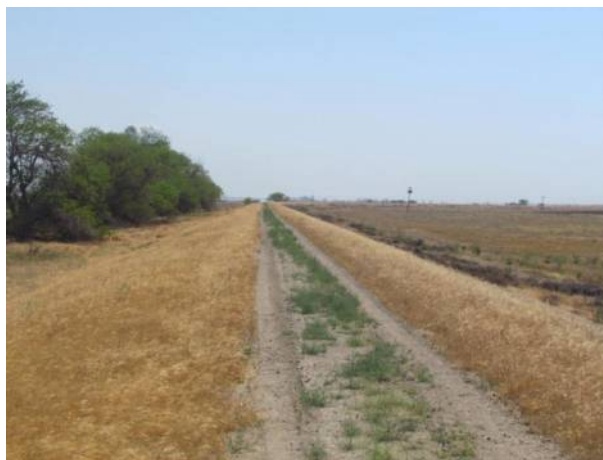
Levee Mile Report Line	1
Start Levee Mile	0.00
End Levee Mile	5.77
Location	Crown
Category	
Item	Crown Surface / Depressions / Rutting
Looking south at typical view of levee crown.	
richard_s_20130610_176.JPG

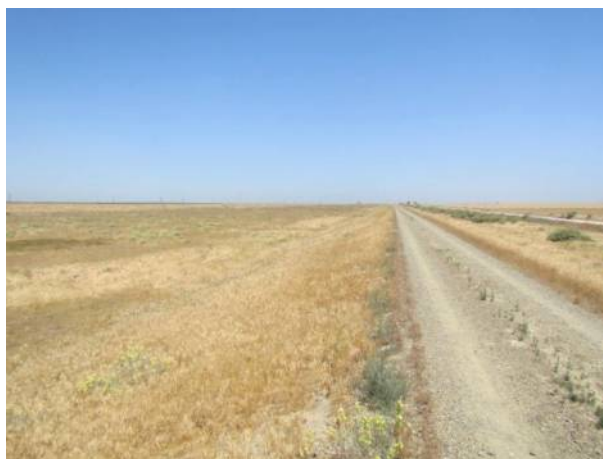
Levee Mile Report Line	2
Start Levee Mile	0.03
End Levee Mile	16.09
Location	Water Side
Category	
Item	Vegetation
Looking south at typical view of waterward slope.	
richard_s_20130610_177.JPG

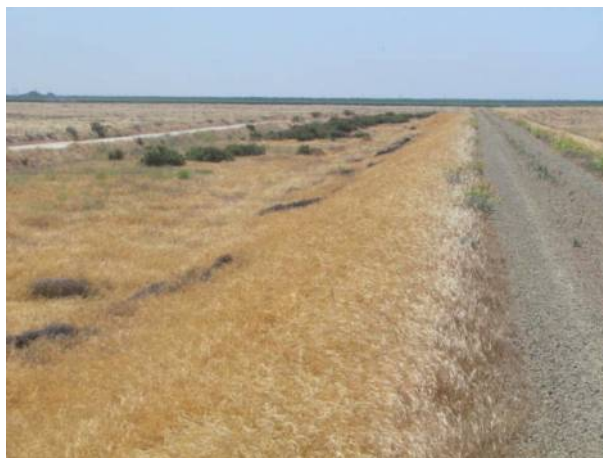
Levee Mile Report Line	3
Start Levee Mile	0.03
End Levee Mile	16.09
Location	Land Side
Category	
Item	Vegetation
Looking south at typical view of landward slope.	
richard_s_20130610_178.JPG

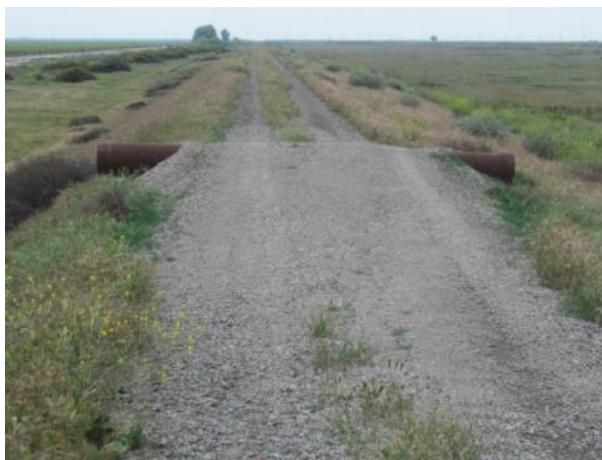
richard_s_20130304_128.jpg

Looking south at unauthorized steel pipe across levee crown.

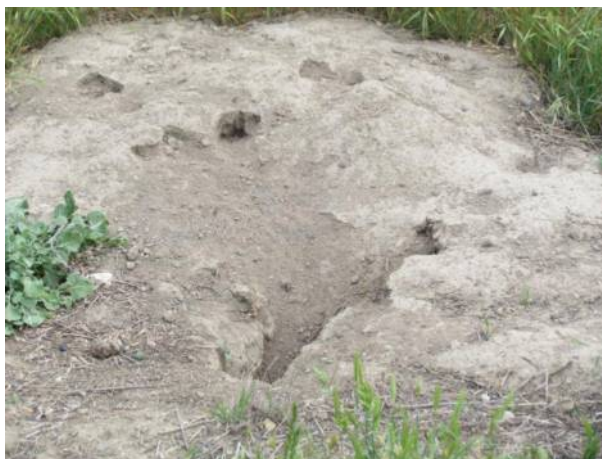
richard_s_20130304_131.jpg

Levee Mile Report Line	5
Start Levee Mile	5.75
End Levee Mile	5.90
Location	Land Side
Category	
Item	Animal Control

Looking at several rodent holes on landside slope.

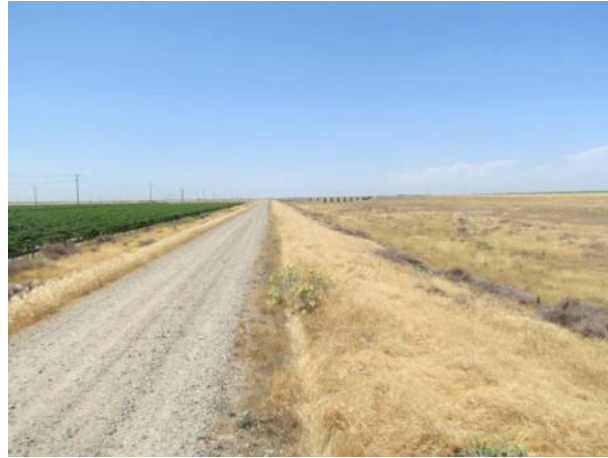
richard_s_20130610_186.JPG

Looking north at typical view of waterward slope.

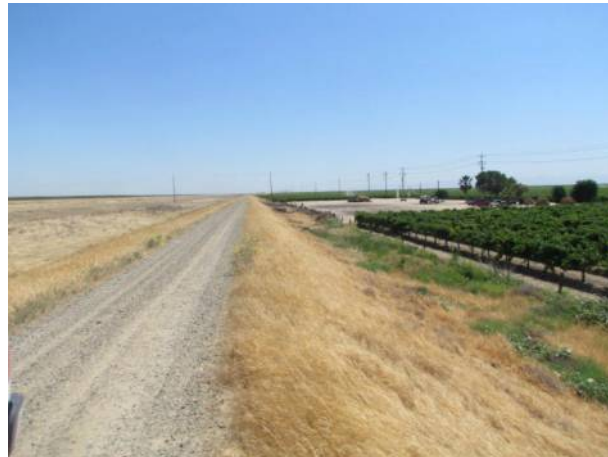
richard_s_20130610_185.JPG

Levee Mile Report Line	2
Start Levee Mile	0.00
End Levee Mile	15.28
Location	Land Side
Category	
Item	Vegetation

Looking north at typical view of landward slope.

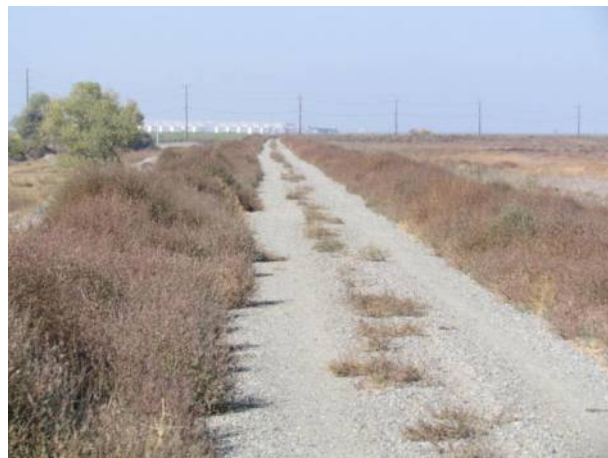
richard_s_20130304_132.JPG

Levee Mile Report Line	4
Start Levee Mile	11.86
End Levee Mile	13.15
Location	Land Side
Category	
Item	Vegetation

Looking north at typical tumble weeds on levee slopes.

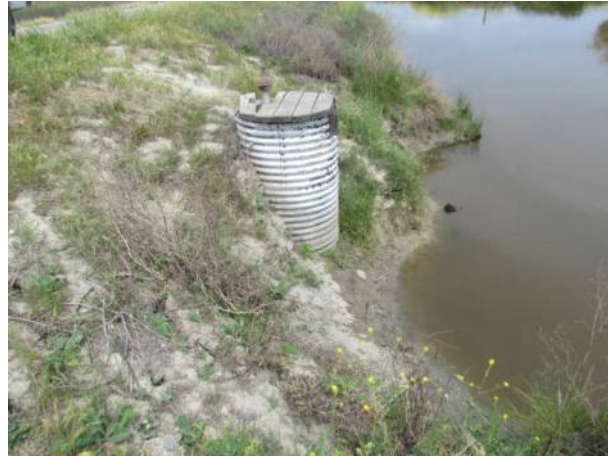
Levee Mile Report Line	3
Start Levee Mile	0.10
End Levee Mile	0.10
Location	Water Side
Category	
Item	Erosion / Bank Caving
Looking north at erosion on waterside toe near screw gate.	
richard_s_20130304_141.jpg

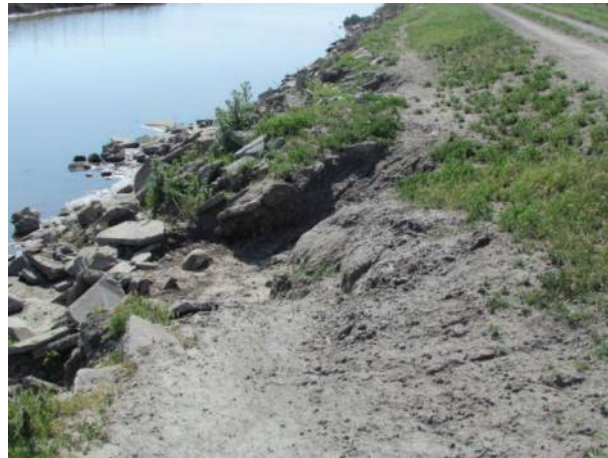
richard_s_20130304_135.jpg

Looking northeast at animal erosion on waterside slope.

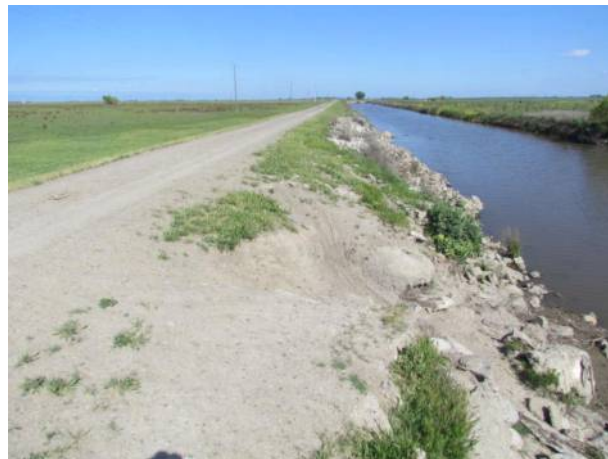
richard_s_20130304_136.jpg

DWR ID: DWR_NA0010_22A_s_2012_8									
5	2.65	3.65		Animal Control	WSA/W Ma	A2 : Repair the levee slope damaged by livestock and prevent large animal access. Inspector Comments: There're several slope stability issues along this channel cause by animal foot traffic that need to be monitored.	37.242563 ° -120.706435 °	37.253465 ° -120.717952 °	1 Y
DWR ID: DWR_NA0010_22A_s_2012_1									
6	3.14	3.14		Trim / Thin Trees	WSA/W Ma	T2 : Thin trees to allow visibility of the ground and room to flood fight.	37.248208 ° -120.711500 °	37.248208 ° -120.711500 °	2
DWR ID: DWR_NA0010_22A_s_2012_2									
7	4.25	4.32		Crown Surface / Depressions / Rutting	CRA/W Ma	C2 : Repair depressions or ruts in the crown or slope.	37.259822 ° -120.725557 °	37.259823 ° -120.725558 °	52
DWR ID: DWR_NA0010_22A_s_2012_52									
8	4.68	4.68	Channels	Encroachments	WS M En	Inspector Comments: Old wooden bridge in channel should be removed.	37.264250 ° -120.731280 °	37.264250 ° -120.731280 °	3 Y

Levee Mile Report Line	5
Start Levee Mile	2.65
End Levee Mile	3.65
Location	Water Side
Category	
Item	Animal Control

Looking south at animal erosion on waterside slope.

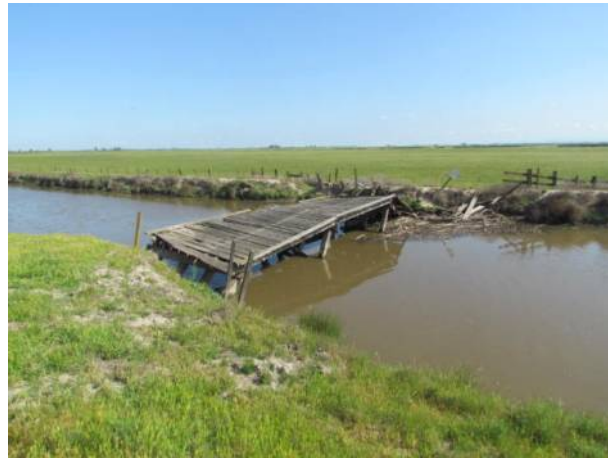
richard_s_20130304_138.jpg

Looking northeast at dilapidated bridge across canal.

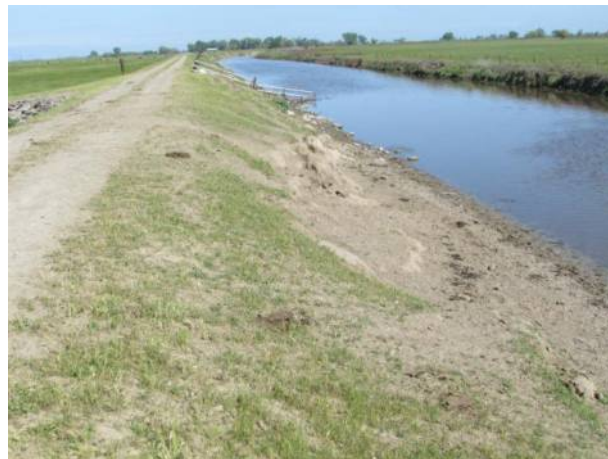
richard_s_20130304_139.jpg

DWR ID: DWR_NA0010_22A_s_2012_3									
9	4.80	4.86		Animal Control	WS M Ma	A2 : Repair the levee slope damaged by livestock and prevent large animal access. Inspector Comments: Erosion caused by livestock on waterside toe.	37.265180 ° -120.732745 °	37.265743 ° -120.733602 °	5 Y
DWR ID: DWR_NA0010_22A_s_2012_5									
10	4.81	4.84		Crown Surface / Depressions / Rutting	CR M Ma	C3 : Add appropriate gravel or road base. Grade and compact.	37.265330 ° -120.732960 °	37.265705 ° -120.733553 °	10
DWR ID: DWR_NA0010_22A_s_2012_10									
11	5.07	5.10		Crown Surface / Depressions / Rutting	CRA/W Ma	C2 : Repair depressions or ruts in the crown or slope. Inspector Comments: Minor rutting on levee crown.	37.267682 ° -120.736597 °	37.267967 ° -120.736913 °	9 Y
DWR ID: DWR_NA0010_22A_s_2012_9									
12	5.09	5.09		Crown Surface / Depressions / Rutting	CRA/W Ma	C2 : Repair depressions or ruts in the crown or slope.	37.267903 ° -120.736878 °	37.267903 ° -120.736878 °	57

Levee Mile Report Line	9
Start Levee Mile	4.80
End Levee Mile	4.86
Location	Water Side
Category	
Item	Animal Control

Looking north at waterside erosion from livestock.

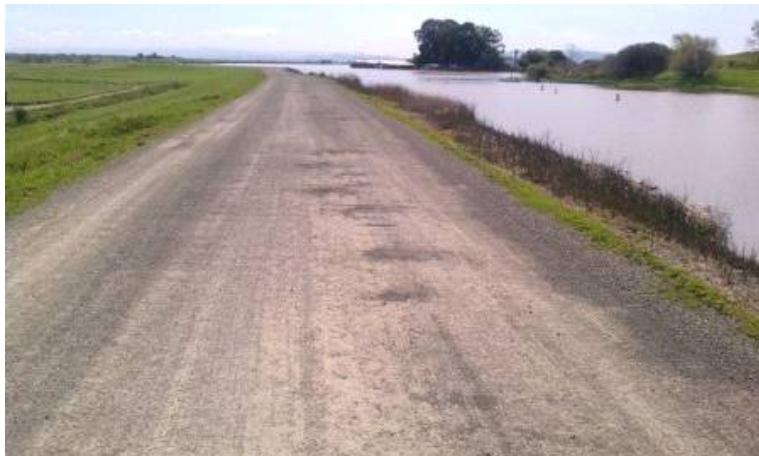
richard_s_20130304_143.jpg

Levee Mile Report Line	11
Start Levee Mile	5.07
End Levee Mile	5.10
Location	Crown
Category	
Item	Crown Surface / Depressions / Rutting

Looking south at rutting on levee crown.

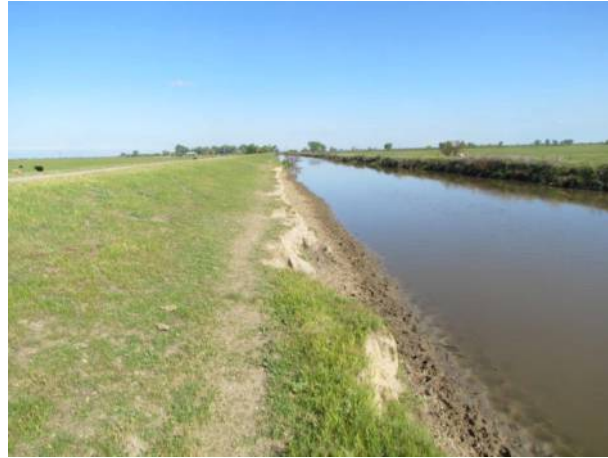
richard_s_20130304_140.jpg

Looking north at livestock erosion along waterside slope and toe.

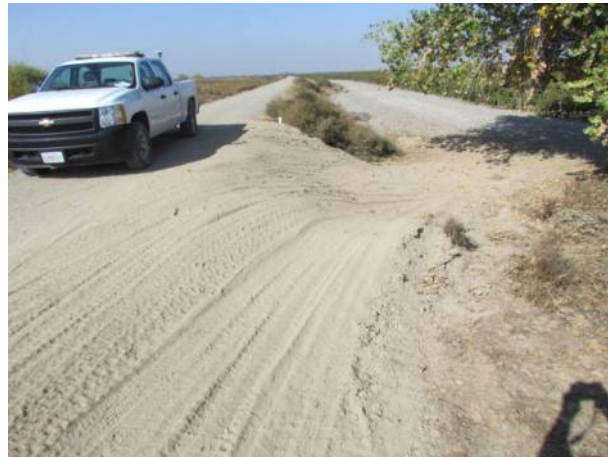
richard_s_20130304_153.JPG

Looking north at slope damage by vehicle traffic.

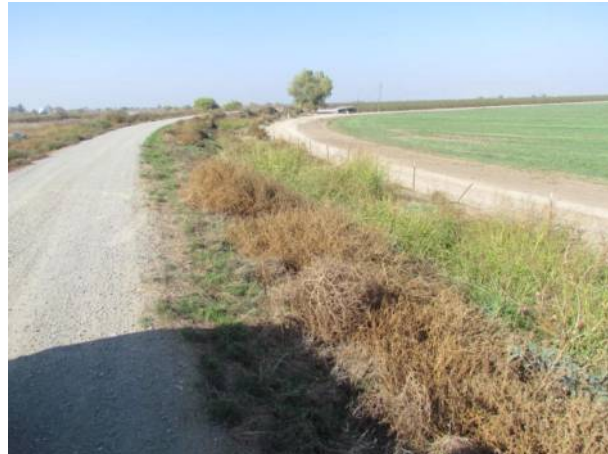
richard_s_20130304_144.JPG

Levee Mile Report Line	6
Start Levee Mile	1.56
End Levee Mile	1.75
Location	Land Side
Category	
Item	Vegetation

Looking south at dense vegetation on landside slope.

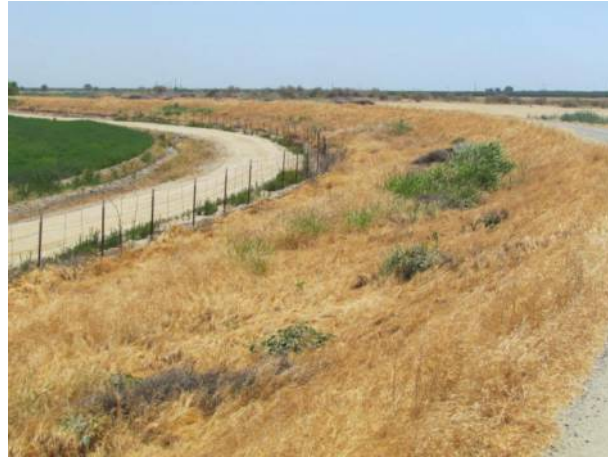
richard_s_20130610_179.JPG

Looking south at typical view of landward slope.

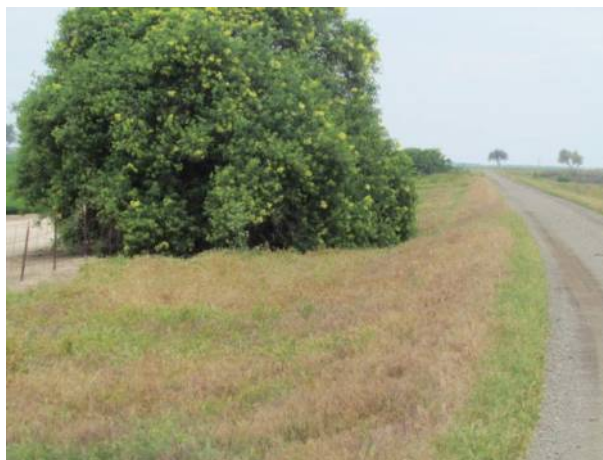
richard_s_20130304_145.jpg

Looking south at elderberry on landside toe and berm.

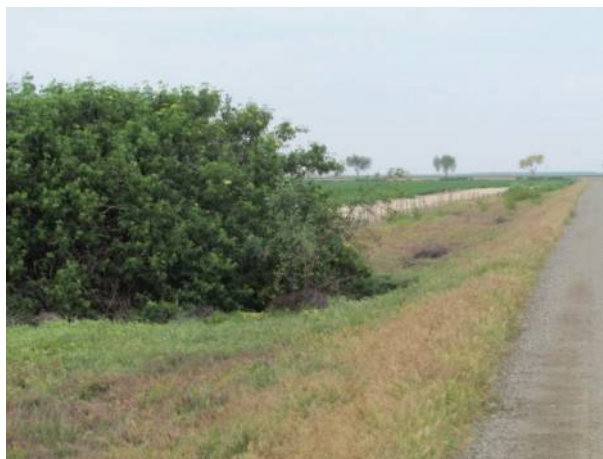
richard_s_20130304_150.jpg

Levee Mile Report Line	10
Start Levee Mile	3.45
End Levee Mile	3.45
Location	Land Side
Category	
Item	Vegetation

Looking south at elderberry on landside toe and berm.

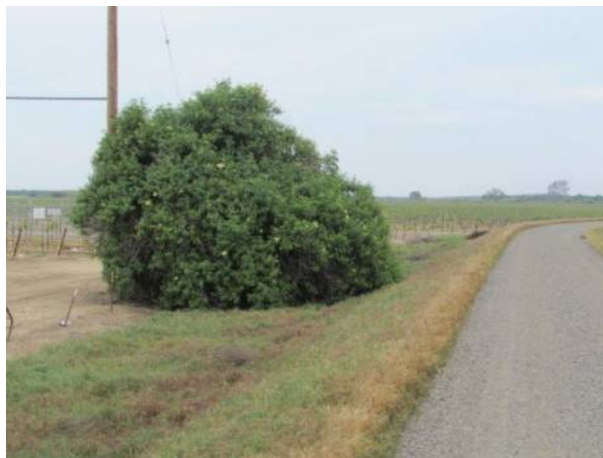
richard_s_20130304_151.jpg

Levee Mile Report Line	11
Start Levee Mile	4.14
End Levee Mile	4.14
Location	Land Side
Category	
Item	Vegetation

Looking south at elderberry on landside toe and berm.

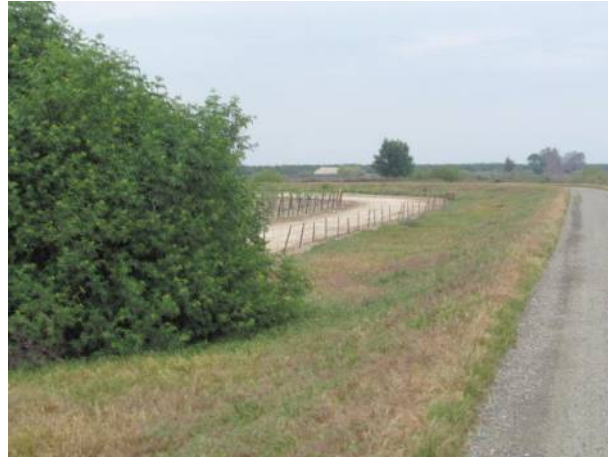
richard_s_20130304_152.jpg

Looking south at elderberry on landside toe and berm.

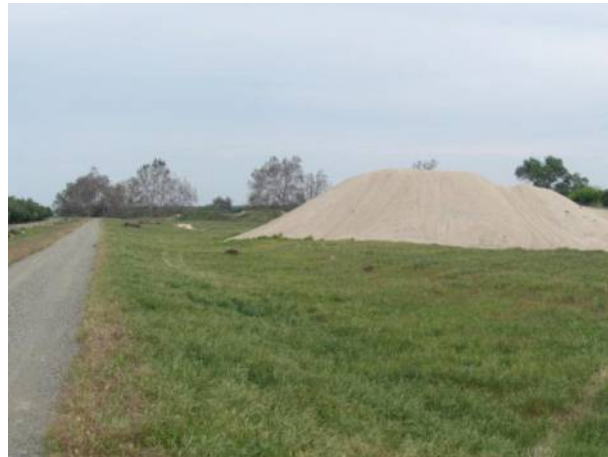
richard_s_20130304_147.jpg

Levee Mile Report Line	13
Start Levee Mile	5.23
End Levee Mile	5.23
Location	Water Side
Category	
Item	Encroachments

Looking south at sand pile 20-30 feet away from waterside slope.

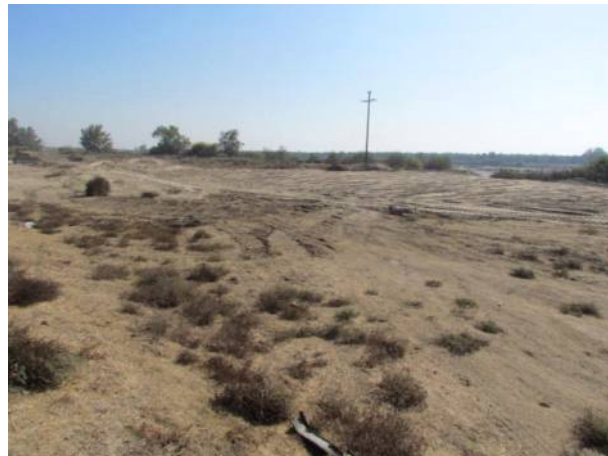
richard_s_20130304_148.JPG

Levee Mile Report Line	13
Start Levee Mile	5.23
End Levee Mile	5.23
Location	Water Side
Category	
Item	Encroachments

Looking southwest at de-graded sandpile in channel.

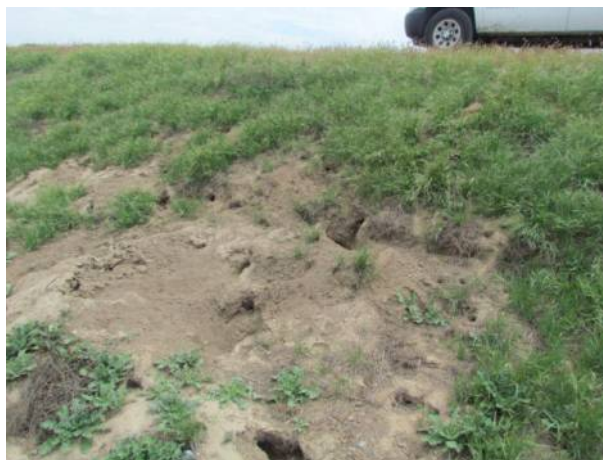
richard_s_20130304_146.jpg

Looking at several rodent holes on landside slope.

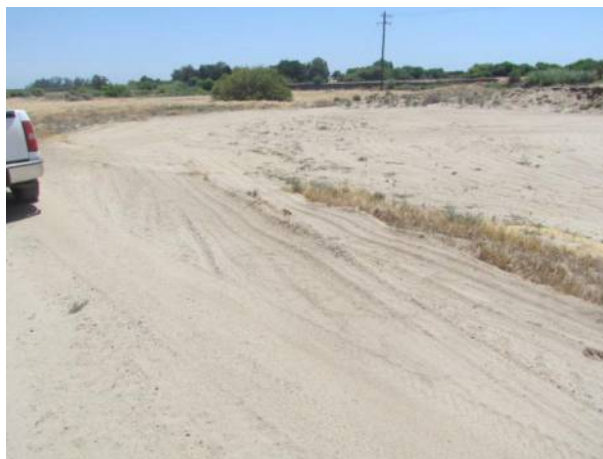
richard_s_20130610_181.JPG

Levee Mile Report Line	17
Start Levee Mile	8.48
End Levee Mile	8.48
Location	Water Side
Category	
Item	Slope Stability

Looking southwest at waterward slope degraded due to vehicle traffic.

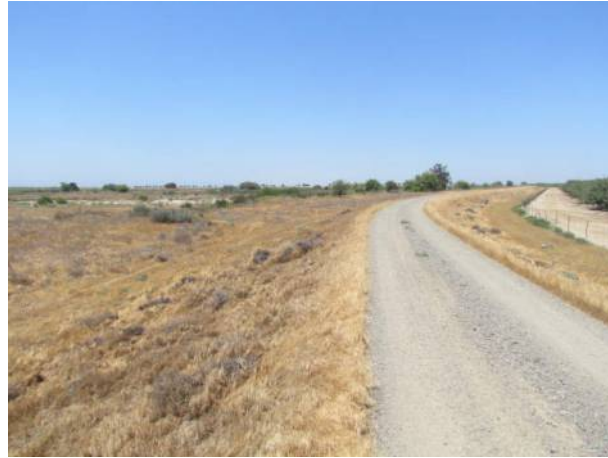
richard_s_20130610_182.JPG

Looking north at typical view of waterward slope.

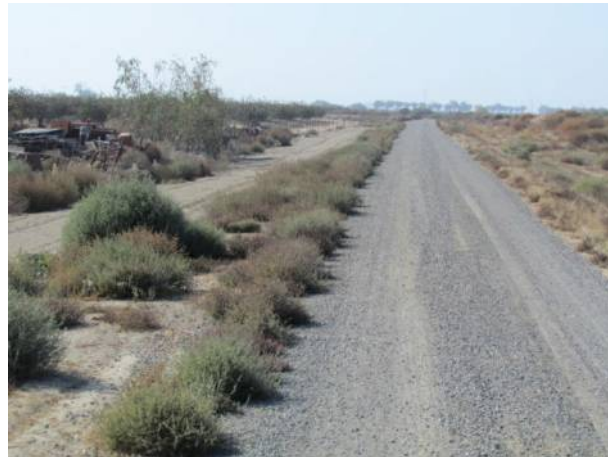
richard_s_20130304_155.JPG

Levee Mile Report Line	2
Start Levee Mile	0.02
End Levee Mile	8.34
Location	Land Side
Category	
Item	Vegetation

Looking north at tumble weeds on landside and waterside slopes.

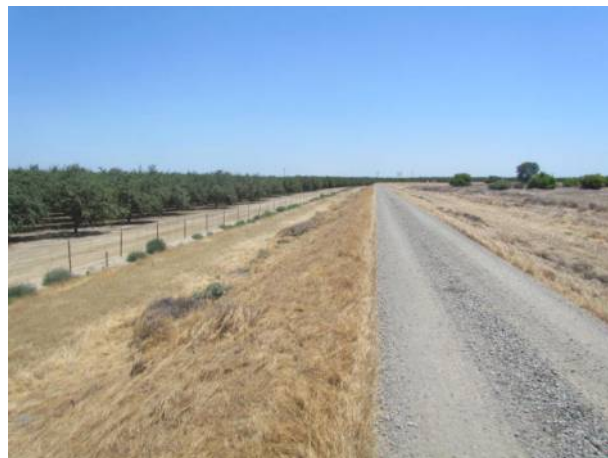
richard_s_20130610_183.JPG

Levee Mile Report Line	2
Start Levee Mile	0.02
End Levee Mile	8.34
Location	Land Side
Category	
Item	Vegetation

Looking north at typical view of landward slope.

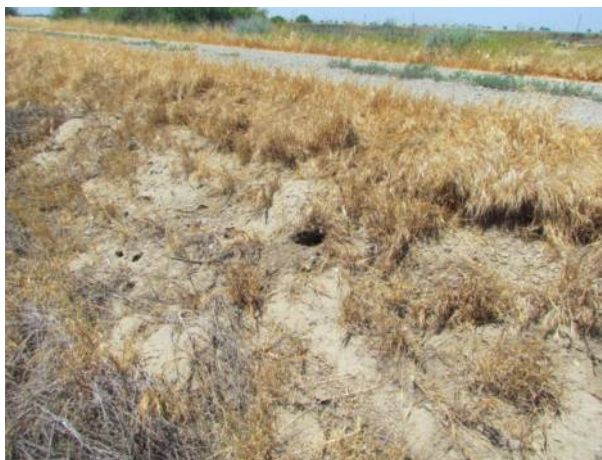
richard_s_20130610_184.JPG

Looking east at one of several rodent holes on landward slope.

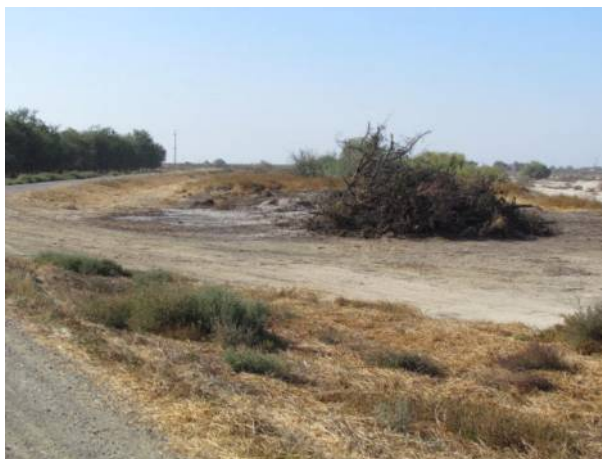
richard_s_20130304_156.JPG

Levee Mile Report Line	7
Start Levee Mile	6.33
End Levee Mile	6.33
Location	Water Side
Category	
Item	Encroachments

Looking north at prunings on waterside berm.

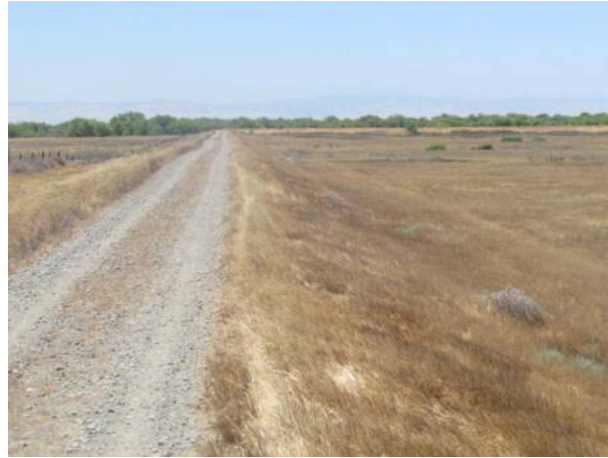
richard_s_20130611_213.JPG

Looking west at typical view of landward slope.

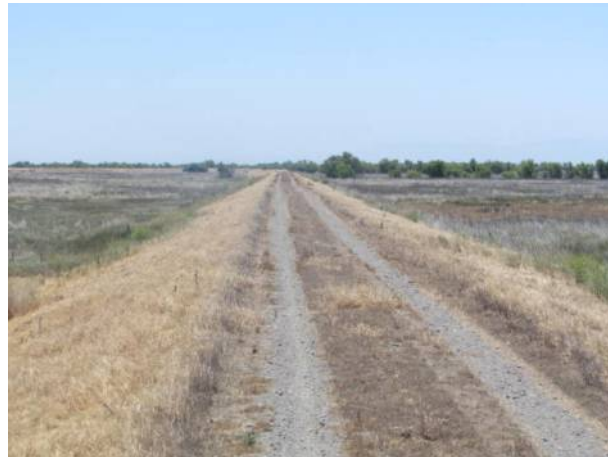
richard_s_20130611_212.JPG

Levee Mile Report Line	2
Start Levee Mile	0.00
End Levee Mile	2.47
Location	Crown
Category	
Item	Crown Surface / Depressions / Rutting

Looking north at vegetation on levee crown.

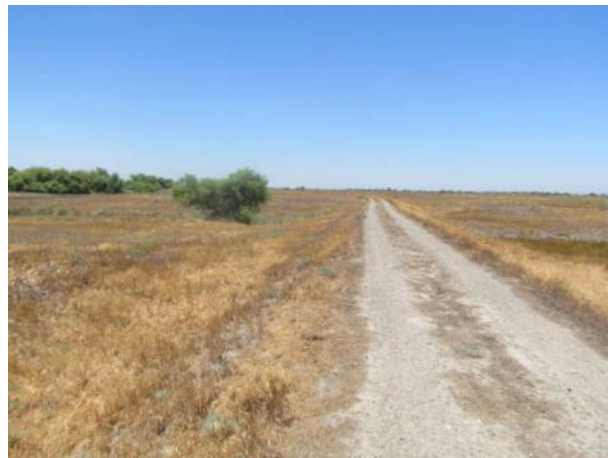
richard_s_20130611_214.JPG

Levee Mile Report Line	3
Start Levee Mile	0.00
End Levee Mile	2.47
Location	Water Side
Category	
Item	Vegetation

Looking east at typical view of waterward slope.

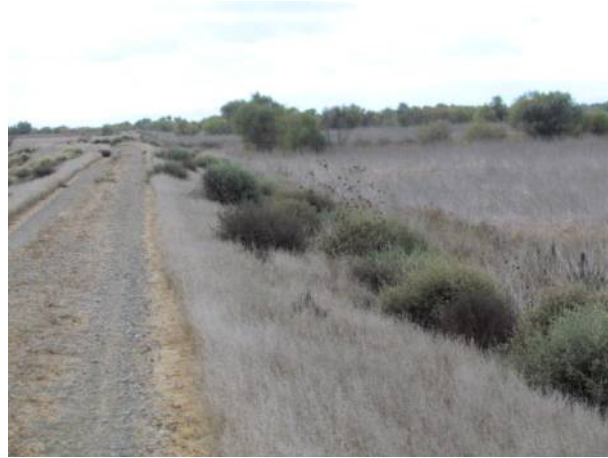
richard_s_20130304_157.JPG

Looking west at typical view of tumble weeds on levee slope.
