**Flood Control Project Maintenance  
Levee Inspections**  
**LMA District Cover Sheet**  
**Spring 2014 Levee Inspection Results**

**Lower San Joaquin Levee District**

**Spring 2014 Levee Inspection Results**

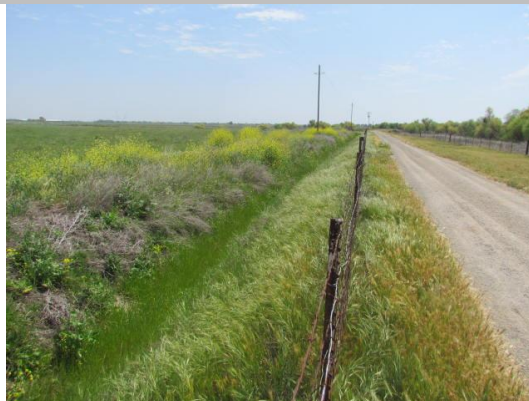
Photo 1 of 2 : richard\_s\_20140417\_541.jpg

LM Start	4.00	Rating **	M	Issue No.	5
LM End	4.08	Issue Type +	En	Location *	LS
Category	Earthen Levee			GPS Latitude/Longitude	
				Start	End
Item	Encroachments			37.310837 °	37.310003 °
				-120.926182 °	-120.925313 °
DWR ID	DWR_NA0010_01_s _ 2012_5				
Action/Comments					
Ditch					
Inspector Comments: Irrigation ditch at landside toe

Looking south at irrigation ditch at landside toe.

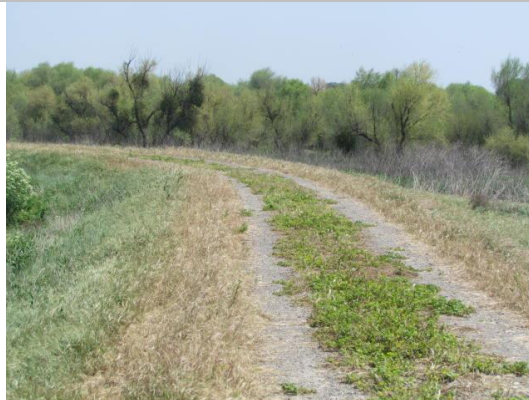
Photo 1 of 3 : richard\_s\_20140417\_558.jpg

LM Start	9.21	Rating **	M	Issue No.	117
LM End	10.76	Issue Type +	Ma	Location *	CR
Category	Earthen Levee			GPS Latitude/Longitude	
				Start	End
Item	Crown Surface / Depressions / Rutting			37.296145 °	37.293077 °
				-120.848588 °	-120.839170 °
DWR ID	DWR_NA0010_01_s _ 2012_117				
Action/Comments					
Add appropriate material and re-grade the levee to bring the crown above the design elevation.					
Inspector Comments: Control vegetation on levee crown.

Looking south at typical view of vegetation on levee crown.

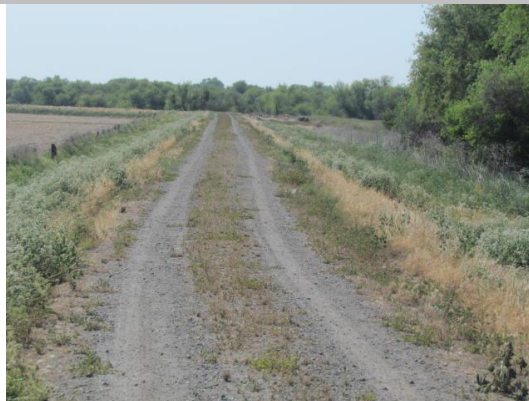
Photo 2 of 3 : richard\_s\_20140417\_559.jpg

LM Start	9.21	Rating **	M	Issue No.	117 (cont)
LM End	10.76	Issue Type +	Ma	Location *	CR
Category	Earthen Levee			GPS Latitude/Longitude	
				Start	End
Item	Crown Surface / Depressions / Rutting			37.296145 °	37.293077 °
				-120.848588 °	-120.839170 °
DWR ID	DWR_NA0010_01_s _ 2012_117				
Action/Comments					
Add appropriate material and re-grade the levee to bring the crown above the design elevation. Inspector Comments: Control vegetation on levee crown.

Looking south at vegetation on levee crown. (Spring 2013)

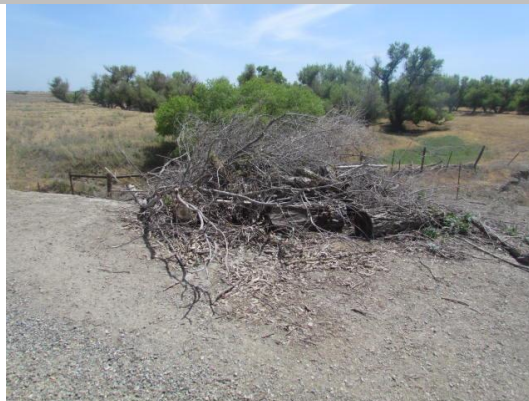
Photo 1 of 1 : richard\_s\_20140520\_848.jpg

LM Start	18.78	Rating **	M	Issue No.	27
LM End	18.78	Issue Type +	En	Location *	WS
Category	Earthen Levee			GPS Latitude/Longitude	
				Start	End
Item	Encroachments			37.205080 °	37.205080 °
				-120.762655 °	-120.762655 °
DWR ID	DWR_NA0010_01_s _ 2014_27				
Action/Comments					
Prunings

Looking at prunings on waterwater shoulder and slope.

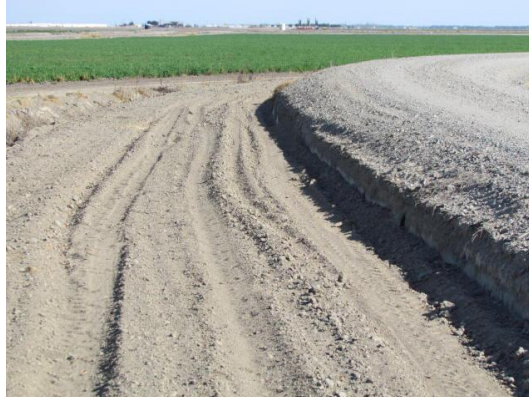
Photo 1 of 2 : richard\_s\_20140417\_547.jpg

LM Start	20.28	Rating **	M	Issue No.	20
LM End	22.02	Issue Type +	Ma	Location *	LS
Category	Earthen Levee			GPS Latitude/Longitude	
				Start	End
Item	Encroachments			37.193426 °	37.172663 °
				-120.760419 °	-120.754894 °
DWR ID	DWR_NA0010_01_f_2012_20				
Action/Comments					
Agricultural tilling					
Inspector Comments: Farmer cutting into landside toe and slope.

Looking west at farmer discing landside slope.

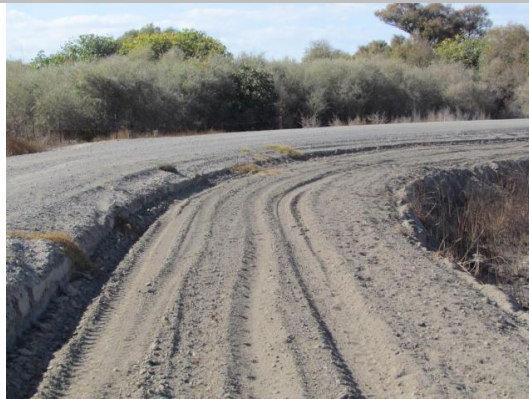
Photo 2 of 2 : richard\_s\_20140417\_548.jpg

LM Start	<b>20.28</b>	Rating **	M	Issue No.	<b>20 (cont)</b>
LM End	<b>22.02</b>	Issue Type +	Ma	Location *	LS

Looking east at farmer discing into landside slope.

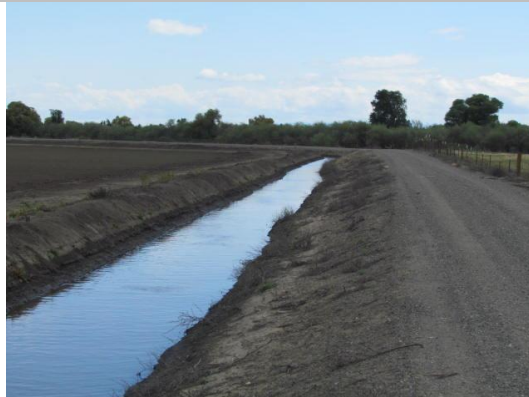
Photo 1 of 2 : richard\_s\_20140417\_549.jpg

LM Start	22.09	Rating **	M	Issue No.	22
LM End	22.56	Issue Type +	En	Location *	LS
Category	Earthen Levee			GPS Latitude/Longitude	
				Start	End
Item	Encroachments			37.169962 °	37.166983 °
				-120.754240 °	-120.750127 °
DWR ID	DWR_NA0010_01_s_2012_22				
Action/Comments					
Ditch

Looking upstream at irrigation at landside toe.

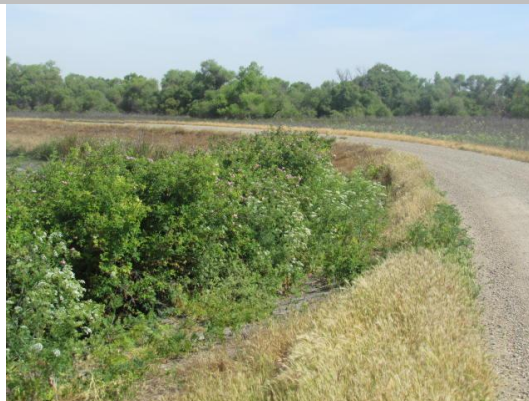
Photo 1 of 1 : richard\_s\_20140520\_839.jpg

LM Start	12.10	Rating **	M	Issue No.	5
LM End	12.10	Issue Type +	Ma	Location *	LS
Category	Earthen Levee			GPS Latitude/Longitude	
				Start	End
Item	Vegetation			37.193504 °	37.193504 °
				-120.763859 °	-120.763859 °
DWR ID	DWR_NA0010_02B_s_2012_5				
Action/Comments					
Remove the wild growth other than native grasses from the levee slopes.					
Inspector Comments: Remove wild roses on landside toe.

Looking north at wildroses on landward slope.

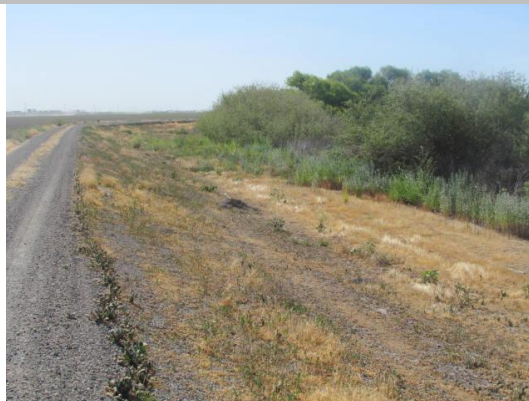
Photo 1 of 2 : richard\_s\_20140520\_831.jpg

LM Start	0.00	Rating **	M	Issue No.	2
LM End	2.16	Issue Type +	Ma	Location *	WS
Category	Earthen Levee			GPS Latitude/Longitude	
				Start	End
Item	Vegetation			37.111974 °	37.088339 °
				-120.587371 °	-120.566930 °
DWR ID	DWR_NA0010_03_s _ 2014_2				
Action/Comments					
Control annual grass and weeds on the levee slopes and easements.

Looking at typical view of waterward slope.

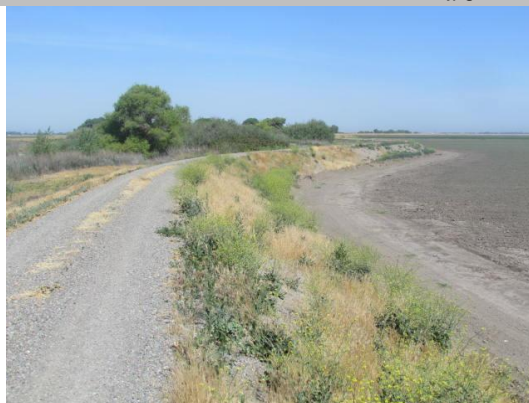
Photo 2 of 2 : richard\_s\_20140520\_832.jpg

LM Start	<b>0.00</b>	Rating **	M	Issue No.	<b>2 (cont)</b>
LM End	<b>2.16</b>	Issue Type +	Ma	Location *	WS

Looking at typical view of landward slope.

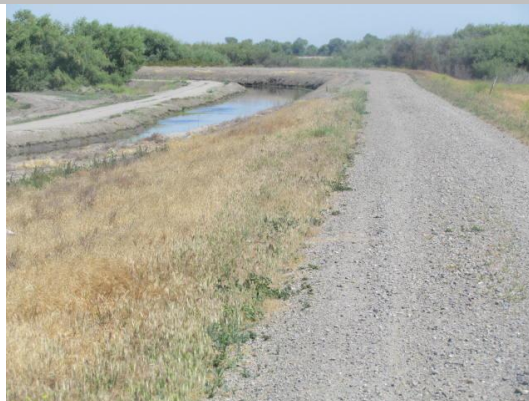
Photo 1 of 1 : richard\_s\_20140520\_833.jpg

LM Start	0.00	Rating **	M	Issue No.	1
LM End	1.58	Issue Type +	Ma	Location *	LS
Category	Earthen Levee			GPS Latitude/Longitude	
				Start	End
Item	Vegetation			37.112522 °	37.095328 °
				-120.589098 °	-120.577941 °
DWR ID	DWR_NA0010_04_s _ 2014_1				
Action/Comments					
Control annual grass and weeds on the levee slopes and easements.

Looking at typical view of landside slope.

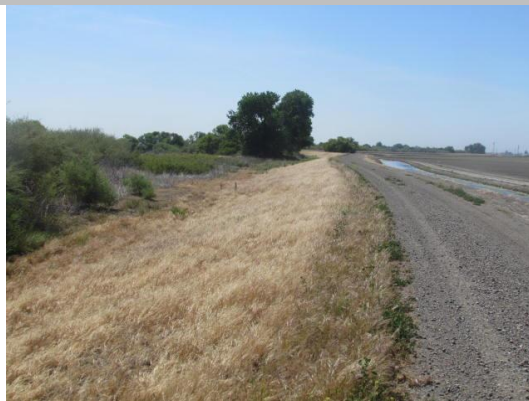
Photo 1 of 1 : richard\_s\_20140520\_834.jpg

LM Start	0.00	Rating **	M	Issue No.	2
LM End	1.58	Issue Type +	Ma	Location *	WS
Category	Earthen Levee			GPS Latitude/Longitude	
				Start	End
Item	Vegetation			37.112522 °	37.095326 °
				-120.589098 °	-120.577943 °
DWR ID	DWR_NA0010_04_s _ 2014_2				
Action/Comments					
Control annual grass and weeds on the levee slopes and easements. Inspector Comments: Typical view of levee slopes.

Looking at typical view of waterward slope.

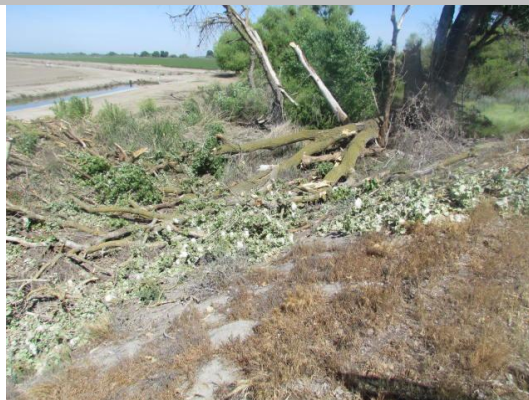
Photo 1 of 1 : richard\_s\_20140520\_835.jpg

LM Start	0.30	Rating **	M	Issue No.	4
LM End	0.30	Issue Type +	En	Location *	LS
Category	Earthen Levee			GPS Latitude/Longitude	
				Start	End
Item	Encroachments			37.109052 °	37.109052 °
				-120.590800 °	-120.590800 °
DWR ID	DWR_NA0010_04_s _ 2014_4				
Action/Comments					
Tree or limb Inspector Comments: Downed tree on landward slope and toe.

Looking east at downed tree and prunings on landward slope and toe.

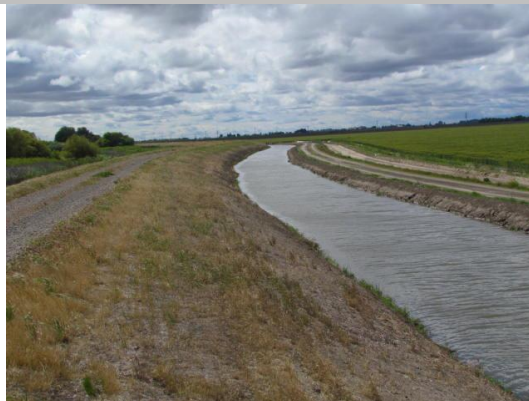
Photo 1 of 3 : richard\_s\_20140417\_748.jpg

LM Start	0.32	Rating **	M	Issue No.	3
LM End	1.49	Issue Type +	En	Location *	CR
Category	Earthen Levee			GPS Latitude/Longitude	
				Start	End
Item	Encroachments			37.108822 °	37.096532 °
				-120.590718 °	-120.578027 °
DWR ID	DWR_NA0010_04_s _ 2012_3				
Action/Comments					
Ditch					
Inspector Comments: Agricultural Ditch within 10' easement.

Looking north at irrigation ditch at landside toe.

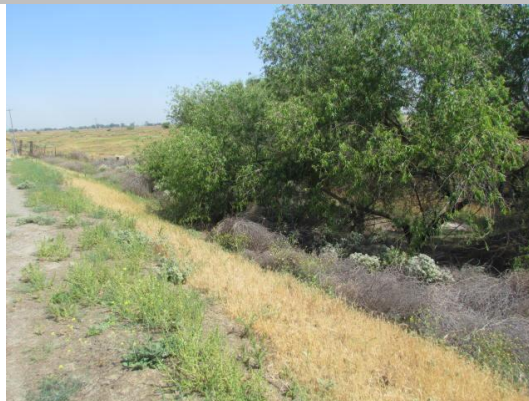
Photo 1 of 1 : richard\_s\_20140417\_762.jpg

LM Start	0.64	Rating **	A/W	Issue No.	24
LM End	0.64	Issue Type +	Ma	Location *	LS
Category	Earthen Levee			GPS Latitude/Longitude	
				Start	End
Item	Trim / Thin Trees			37.273445 °	37.273445 °
				-120.815210 °	-120.815210 °
DWR ID	DWR_NA0010_05_s _ 2013_24				
Action/Comments					
Trim trees to at least five feet above ground level.

Looking east at untrimmed trees on landward toe.

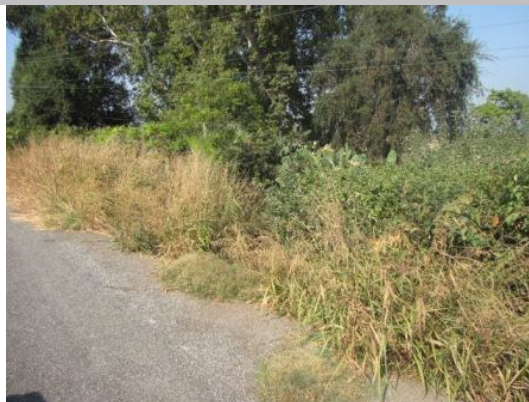
Photo 1 of 2 : richard\_s\_20140417\_752.jpg

LM Start	2.81	Rating **	A/W	Issue No.	3
LM End	2.86	Issue Type +	Ma	Location *	LS
Category	Earthen Levee			GPS Latitude/Longitude	
				Start	End
Item	Trim / Thin Trees			37.256803 °	37.256835 °
				-120.785407 °	-120.784528 °
DWR ID	DWR_NA0010_05_s _ 2012_3				
Action/Comments					
Thin trees to allow visibility of the ground and room to flood fight.

Looking south at dense trees on landside slope.

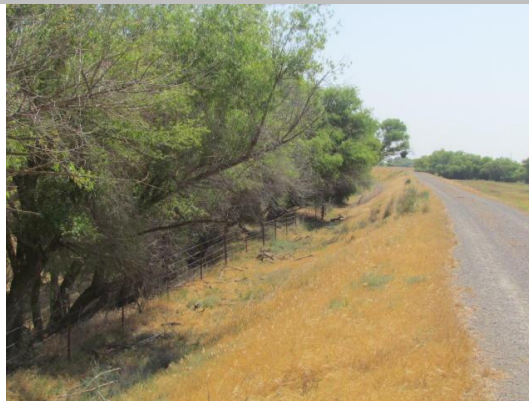
Photo 2 of 2 : richard\_s\_20140417\_753.jpg

LM Start	2.81	Rating **	A/W	Issue No.	3 (cont)
LM End	2.86	Issue Type +	Ma	Location *	LS
Category	Earthen Levee			GPS Latitude/Longitude	
				Start	End
Item	Trim / Thin Trees			37.256803 °	37.256835 °
				-120.785407 °	-120.784528 °
DWR ID	DWR_NA0010_05_s _ 2012_3				
Action/Comments					
Thin trees to allow visibility of the ground and room to flood fight.

Looking south at trimmed trees on landward slope and toe.

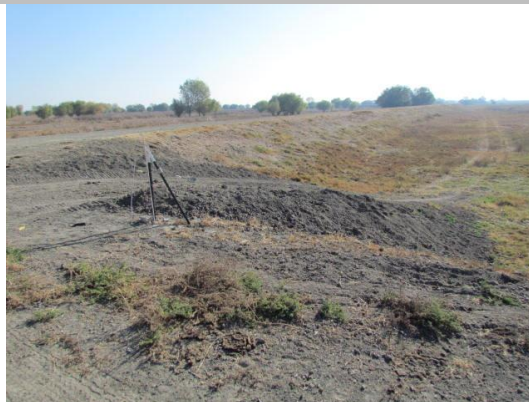
Photo 1 of 3 : richard\_s\_20140417\_754.jpg

LM Start	3.19	Rating **	M	Issue No.	7
LM End	3.19	Issue Type +	En	Location *	WS
Category	Earthen Levee			GPS Latitude/Longitude	
				Start	End
Item	Encroachments			37.256554 °	37.256554 °
				-120.778847 °	-120.778847 °
DWR ID	DWR_NA0010_05_f _ 2012_7				
Action/Comments					
Ramp Inspector Comments: Unauthorized ramp on waterside slope.

Looking south at unauthorized ramp on waterside slope.

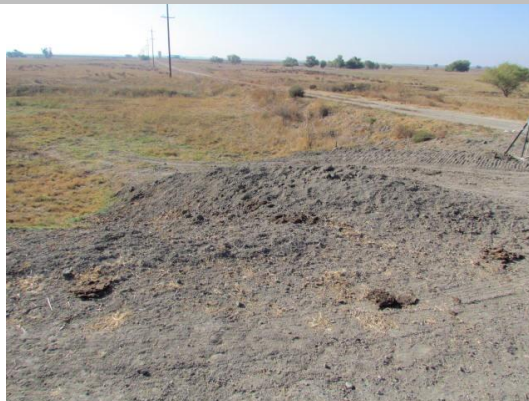
Photo 2 of 3 : richard\_s\_20140417\_755.jpg

LM Start	3.19	Rating **	M	Issue No.	7 (cont)	
LM End	3.19	Issue Type +	En	Location *	WS	
Category	Earthen Levee			GPS Latitude/Longitude		
				Start		End
Item	Encroachments			37.256554 °	37.256554 °	
				-120.778847 °	-120.778847 °	
DWR ID	DWR_NA0010_05_f_2012_7					
Action/Comments						
Ramp						
Inspector Comments: Unauthorized ramp on waterside slope.

Looking northwest at unauthorized ramp on waterside slope.

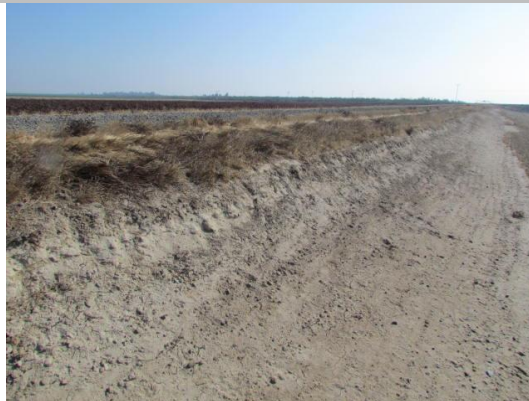
Photo 2 of 3 : richard\_s\_20140417\_764.jpg

LM Start	<b>29.58</b>	Rating **	M	Issue No.	<b>171 (cont)</b>
LM End	<b>29.70</b>	Issue Type +	Ma	Location *	WS

Looking east at livestock erosion on landward slope.

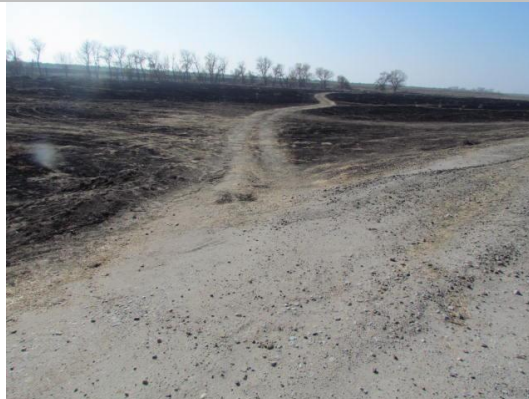
Photo 1 of 1 : richard\_s\_20140417\_757.jpg

LM Start	34.50	Rating **	M	Issue No.	11
LM End	34.50	Issue Type +	En	Location *	WS
Category	Earthen Levee			GPS Latitude/Longitude	
				Start	End
Item	Encroachments			36.978555 °	36.978555 °
				-120.368467 °	-120.368467 °
DWR ID	DWR_NA0010_05_s _ 2012_11				
Action/Comments					
Ramp					
Inspector Comments: Unauthorized ramp on waterside slope.

Looking west at unauthorized ramp on waterward slope.

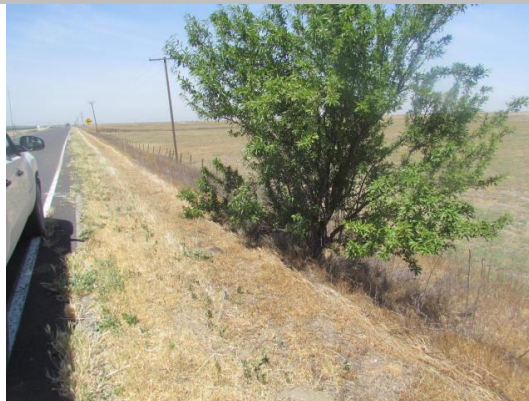
Photo 1 of 1 : richard\_s\_20140520\_837.jpg

LM Start	11.57	Rating **	M	Issue No.	14
LM End	11.57	Issue Type +	Ma	Location *	WS
Category	Earthen Levee			GPS Latitude/Longitude	
				Start	End
Item	Trim / Thin Trees			37.186189 °	37.186189 °
				-120.668476 °	-120.668476 °
DWR ID	DWR_NA0010_06_s _ 2014_14				
Action/Comments					
Trim trees to at least five feet above ground level. Inspector Comments: Tree is located along Sandy Mush Rd. on waterward slope.

Looking east at tree on waterward slope.

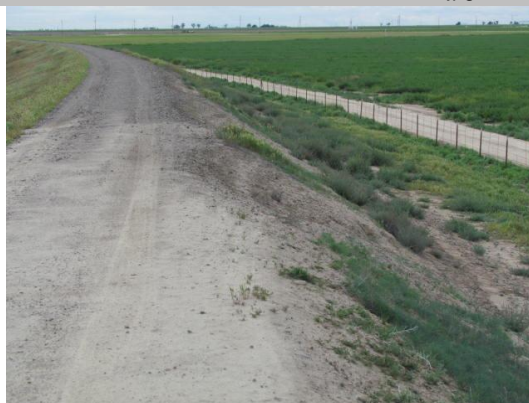
Photo 2 of 4 : richard\_s\_20140417\_769.jpg

LM Start	<b>27.56</b>	Rating **	M	Issue No.	<b>3 (cont)</b>
LM End	<b>27.87</b>	Issue Type +	Ma	Location *	LS

Looking south at livestock erosion on landside shoulder and slope.

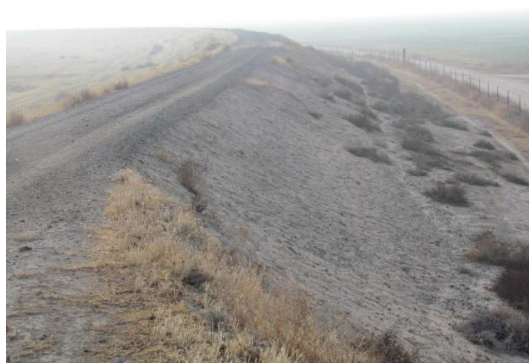
Photo 4 of 4 : richard\_s\_20140417\_771.jpg

Looking south at livestock erosion on landward slope. (Fall 2013)

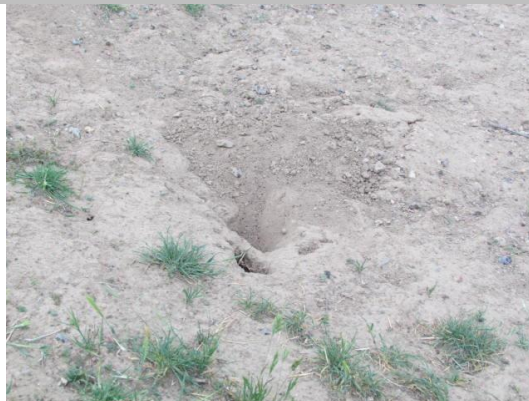
Photo 1 of 2 : richard\_s\_20140417\_766.jpg

LM Start	31.01	Rating **	A/W	Issue No.	2
LM End	31.01	Issue Type +	Ma	Location *	LS
Category	Earthen Levee			GPS Latitude/Longitude	
				Start	End
Item	Animal Control			37.017955 °	37.017955 °
				-120.435017 °	-120.435017 °
DWR ID	DWR_NA0010_06_s _ 2012_2				
Action/Comments					
Exterminate rodents and backfill and compact or grout burrows.

Looking at typical rodent hole on landside slope.

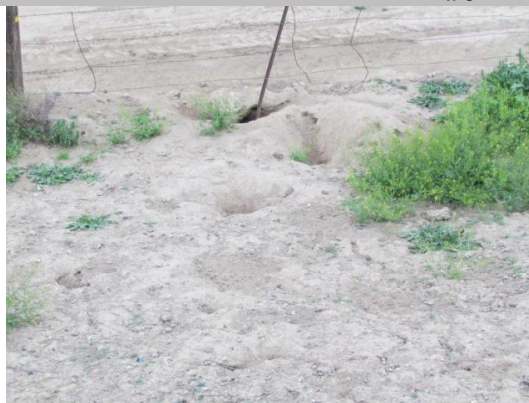
Photo 2 of 2 : richard\_s\_20140417\_767.jpg

LM Start	<b>31.01</b>	Rating **	A/W	Issue No.	<b>2 (cont)</b>
LM End	<b>31.01</b>	Issue Type +	Ma	Location *	LS

Looking west at rodent holes on landside slope and toe near fence line.

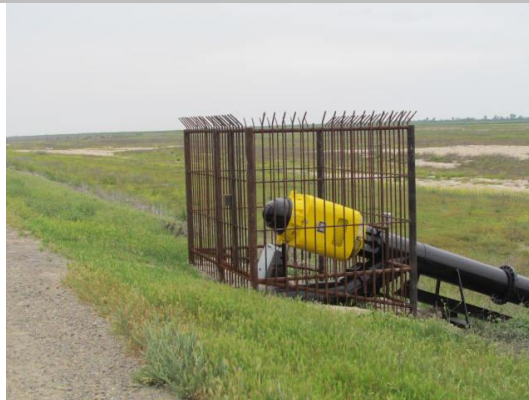
Photo 1 of 1 : richard\_s\_20140417\_779.jpg

LM Start	32.99	Rating **	M	Issue No.	123
LM End	32.99	Issue Type +	En	Location *	WS
Category	Earthen Levee			GPS Latitude/Longitude	
				Start	End
Item	Encroachments			36.995667 °	36.995667 °
				-120.412910 °	-120.412910 °
DWR ID	DWR_NA0010_06_s _ 2012_123				
Action/Comments					
Fence

Looking northeast at new metal fence around slant pump on waterside slope.

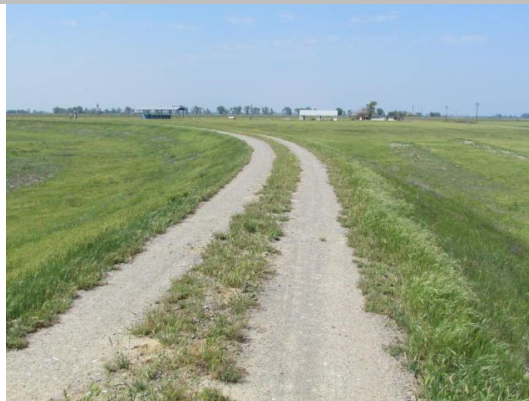
Photo 1 of 2 : richard\_s\_20140417\_786.jpg

Looking east at vegetation on levee crown.

LM Start	0.11	Rating **	A/W	Issue No.	30
LM End	2.57	Issue Type +	Ma	Location *	CR
Category	Earthen Levee			GPS Latitude/Longitude	
				Start	End
Item	Crown Surface / Depressions / Rutting			37.256091 °	37.255397 °
				-120.770417 °	-120.735555 °
DWR ID	DWR_NA0010_07_s _ 2012_30				
Action/Comments					
Add appropriate material and re-grade the levee to bring the crown above the design elevation.

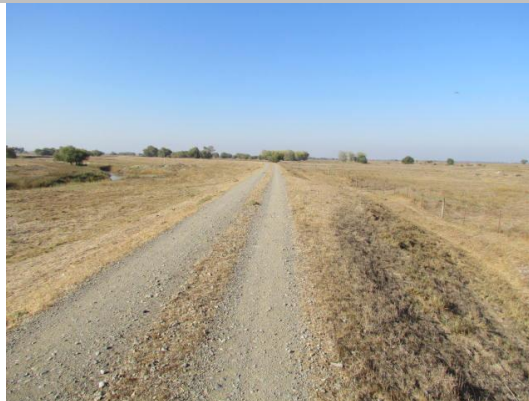
Photo 2 of 2 : richard\_s\_20140417\_787.jpg

Looking east at un-regraded levee crown. (Fall 2012)

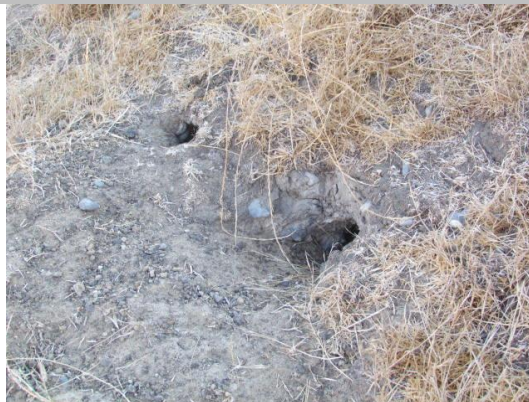
Photo 1 of 2 : richard\_s\_20140417\_781.jpg

Looking north at several rodent holes on landward slope.

LM Start	1.22	Rating **	M	Issue No.	1
LM End	1.22	Issue Type +	Ma	Location *	LS
Category	Earthen Levee			GPS Latitude/Longitude	
				Start	End
Item	Animal Control			37.264387 °	37.264387 °
				-120.755805 °	-120.755805 °
DWR ID	DWR_NA0010_07_f _ 2012_1				
Action/Comments					
Exterminate rodents and backfill and compact or grout burrows.

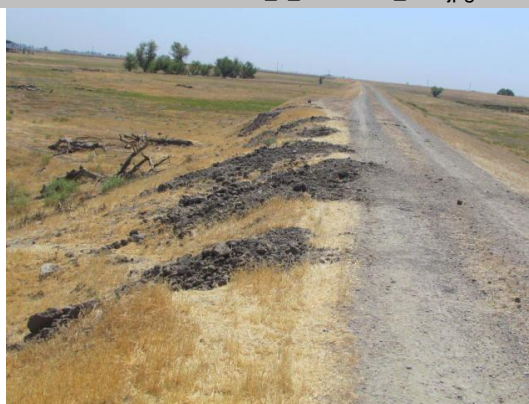
Photo 4 of 4 : richard\_s\_20140417\_785.jpg

Looking south at landward slope.

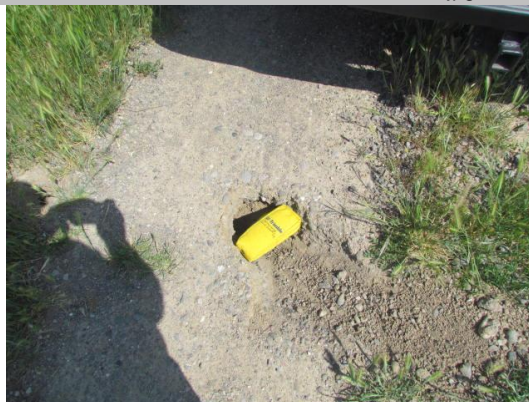
Photo 1 of 3 : richard\_s\_20140417\_788.jpg

Looking at rodent hole on levee crown.

LM Start	1.86	Rating **	A/W	Issue No.	31
LM End	1.86	Issue Type +	Ma	Location *	CR
Category	Earthen Levee			GPS Latitude/Longitude	
				Start	End
Item	Animal Control			37.261670 °	37.261670 °
				-120.745010 °	-120.745010 °
DWR ID	DWR_NA0010_07_s _ 2012_31				
Action/Comments					
No rodents visible, but rodent burrows visible; need to backfill and compact or grout burrows. Inspector Comments: Large rodent holes on crown of levee and landside shoulder of levee.

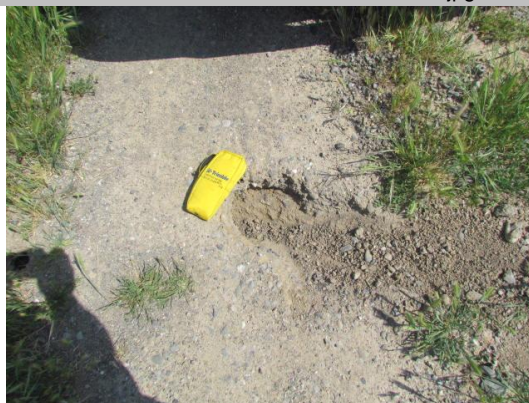
Photo 2 of 3 : richard\_s\_20140417\_789.jpg

Looking at rodent hole on levee crown.

LM Start	1.86	Rating **	A/W	Issue No.	31 (cont)	
LM End	1.86	Issue Type +	Ma	Location *	CR	
Category	Earthen Levee			GPS Latitude/Longitude		
				Start	End	
Item	Animal Control			37.261670 °	37.261670 °	
				-120.745010 °	-120.745010 °	
DWR ID	DWR_NA0010_07_s _ 2012_31					
Action/Comments						
No rodents visible, but rodent burrows visible; need to backfill and compact or grout burrows. Inspector Comments: Large rodent holes on crown of levee and landside shoulder of levee.

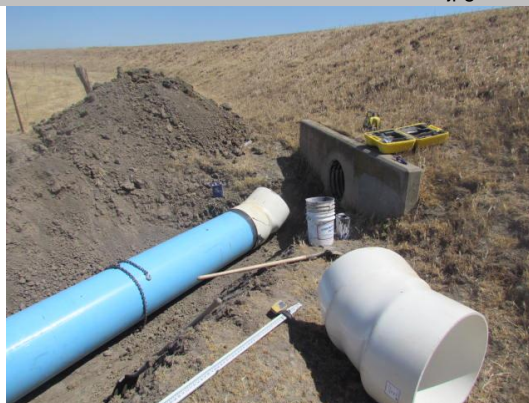
Photo 1 of 4 : richard\_s\_20140519\_805.jpg

LM Start	2.48	Rating **	M	Issue No.	7
LM End	2.48	Issue Type +	En	Location *	LS
Category	Earthen Levee			GPS Latitude/Longitude	
				Start	End
Item	Encroachments			37.255830 °	37.255830 °
				-120.737255 °	-120.737255 °
DWR ID	DWR_NA0010_07_s _ 2014_7				
Action/Comments					
Pipe

Looking east at installation of 18" pvc pipe into 24 inch drain pipe on landside slope.

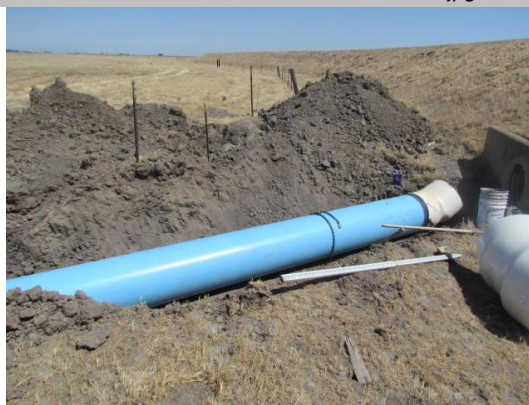
Photo 2 of 4 : richard\_s\_20140519\_806.jpg

Looking southeast at 18" pvc pipe.

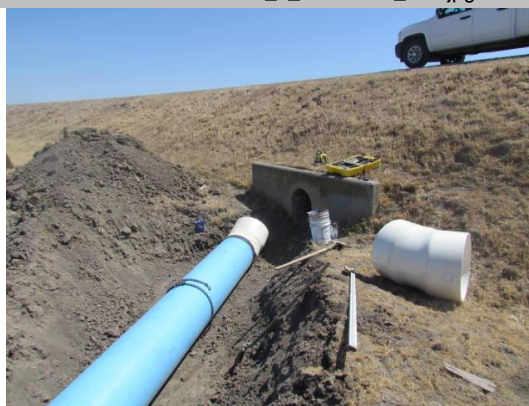
Photo 3 of 4 : richard\_s\_20140519\_807.jpg

Looking north at 18" pipe.

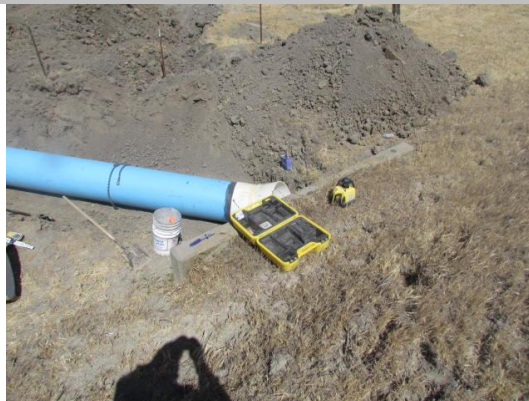
Photo 4 of 4 : richard\_s\_20140519\_808.jpg

Looking south at 18" pipe.

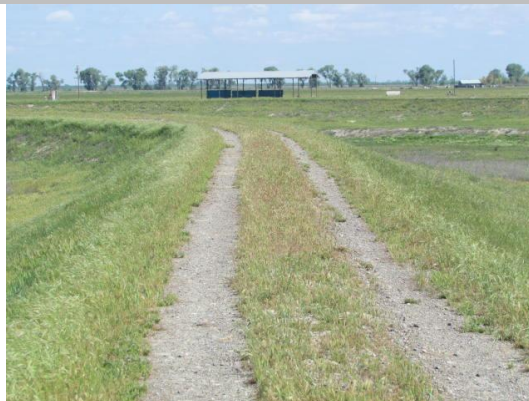
Photo 1 of 4 : richard\_s\_20140417\_795.jpg

Looking west at vegetation on levee crown.

LM Start	0.00	Rating **	M	Issue No.	28
LM End	2.22	Issue Type +	Ma	Location *	CR
Category	Earthen Levee			GPS Latitude/Longitude	
				Start	End
Item	Crown Surface / Depressions / Rutting			37.253178 °	37.256802 °
				-120.768513 °	-120.740452 °
DWR ID	DWR_NA0010_08_s _ 2012_28				
Action/Comments					
Add appropriate material and re-grade the levee to bring the crown above the design elevation.

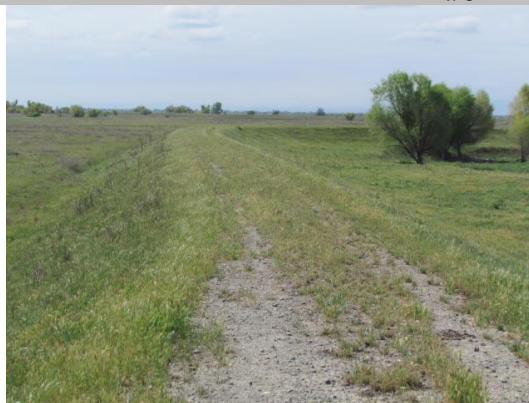
Photo 2 of 4 : richard\_s\_20140417\_796.jpg

Looking east at vegetation on levee crown.

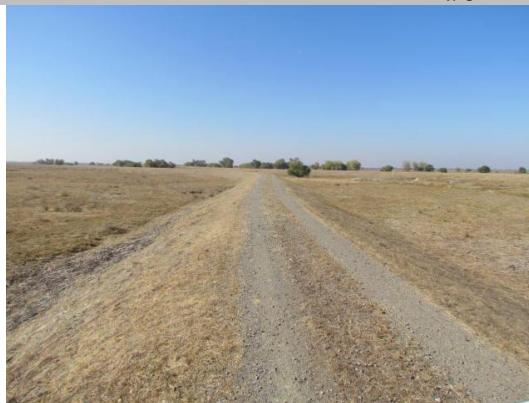
Photo 3 of 4 : richard\_s\_20140417\_797.jpg

Looking east at un-regraded levee crown. (Fall 2012)

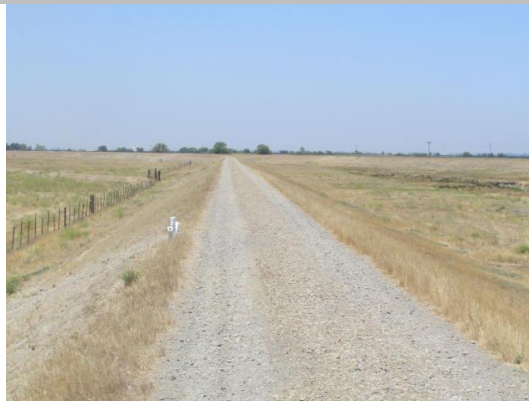
Photo 4 of 4 : richard\_s\_20140417\_798.jpg

Looking east at levee crown.

LM Start	0.00	Rating **	M	Issue No.	28 (cont)	
LM End	2.22	Issue Type +	Ma	Location *	CR	
Category	Earthen Levee			GPS Latitude/Longitude		
				Start		End
Item	Crown Surface / Depressions / Rutting			37.253178 °	37.256802 °	
				-120.768513 °	-120.740452 °	
DWR ID	DWR_NA0010_08_s _ 2012_28					
Action/Comments						
Add appropriate material and re-grade the levee to bring the crown

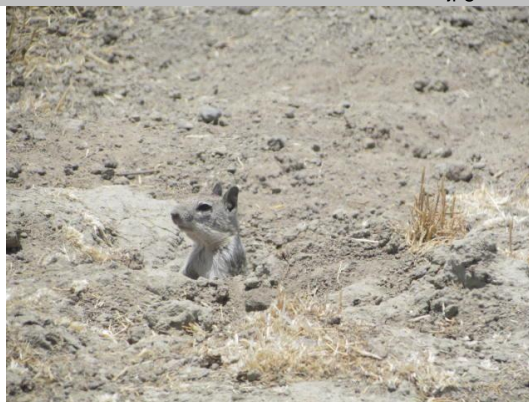
Photo 1 of 1 : richard\_s\_20140417\_794.jpg

Looking west at rodent holes on landward slope.

LM Start	1.38	Rating **	M	Issue No.	8
LM End	1.38	Issue Type +	Ma	Location *	LS
Category	Earthen Levee			GPS Latitude/Longitude	
				Start	End
Item	Animal Control			37.263175 °	37.263175 °
				-120.752307 °	-120.752307 °
DWR ID	DWR_NA0010_08_s _ 2013_8				
Action/Comments					
Exterminate rodents and backfill and compact or grout burrows.

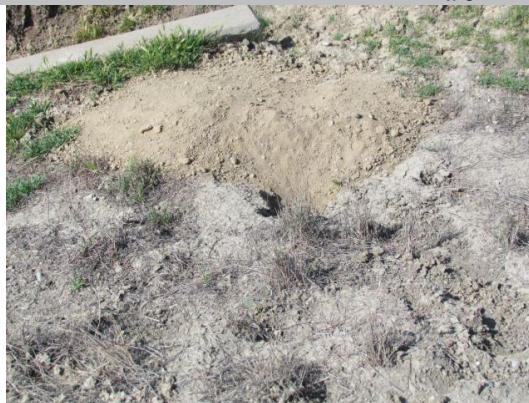
Photo 2 of 3 : richard\_s\_20140417\_792.jpg

LM Start	2.07	Rating **	M	Issue No.	7
LM End	2.12	Issue Type +	Ma	Location *	LS
Category	Earthen Levee			GPS Latitude/Longitude	
				Start	End
Item	Animal Control			37.258063 °	37.257688 °
				-120.742460 °	-120.741573 °
DWR ID	DWR_NA0010_08_s_2012_7				
Action/Comments					
Exterminate rodents and backfill and compact or grout burrows. Inspector Comments: Several rodent holes were noted on landside slope near drainage pipe.

Looking at typical rodent hole on landside slope near headwall.

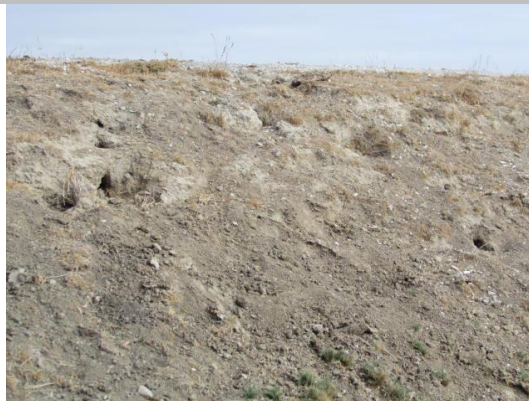
Photo 3 of 3 : richard\_s\_20140417\_793.jpg

Looking south at several rodent holes on landward slope.

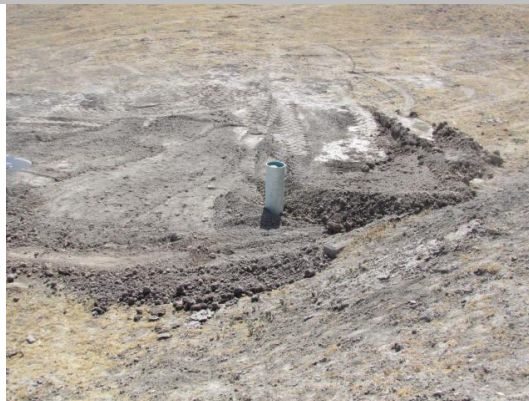
Photo 1 of 3 : richard\_s\_20140519\_809.jpg

LM Start	2.12	Rating **	M	Issue No.	6
LM End	2.12	Issue Type +	En	Location *	LS
Category	Earthen Levee			GPS Latitude/Longitude	
				Start	End
Item	Encroachments			37.257781 °	37.257781 °
				-120.741556 °	-120.741556 °
DWR ID	DWR_NA0010_08_s_2014_6				
Action/Comments					
Pipe

Looking meter connect to 18" pvc pipe on landside.

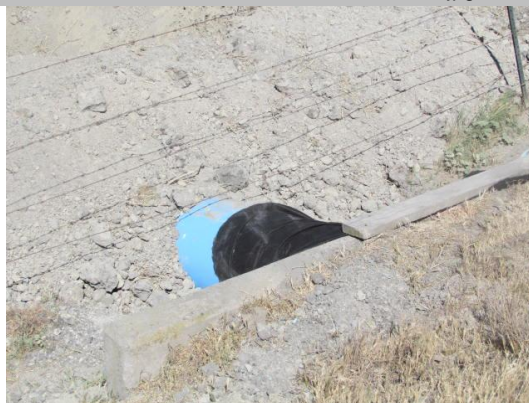
Photo 2 of 3 : richard\_s\_20140519\_810.jpg

Looking north at 18" pvc pipe connected to 24" drain pipe on landside.

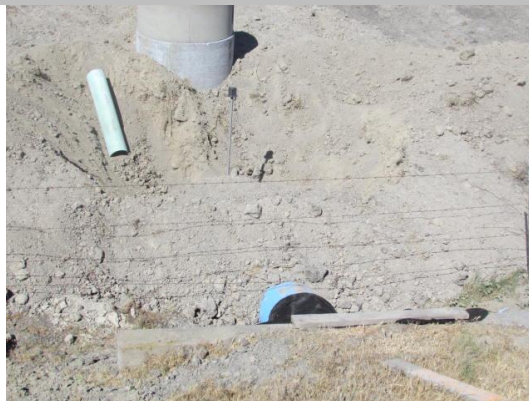
Photo 3 of 3 : richard\_s\_20140519\_811.jpg

Looking north at 18" pvc pipe connected to 24" draing pipe on landside.

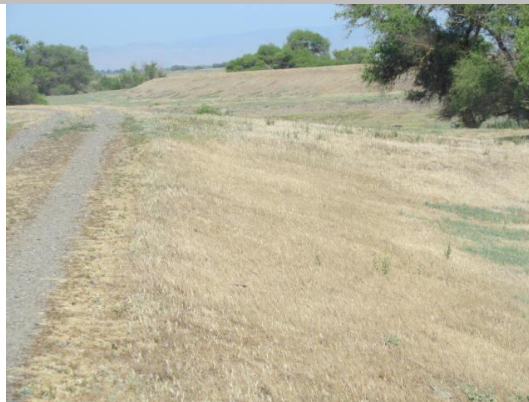
Photo 1 of 1 : richard\_s\_20140519\_817.jpg

Looking west at typical view of levee slopes.

LM Start	0.01	Rating **	M	Issue No.	1
LM End	0.88	Issue Type +	Ma	Location *	LS
Category	Earthen Levee			GPS Latitude/Longitude	
				Start	End
Item	Vegetation			37.220130 °	37.220058 °
				-120.712960 °	-120.698264 °
DWR ID	DWR_NA0010_09_s _ 2014_1				
Action/Comments					
Control annual grass and weeds on the levee slopes and easements.

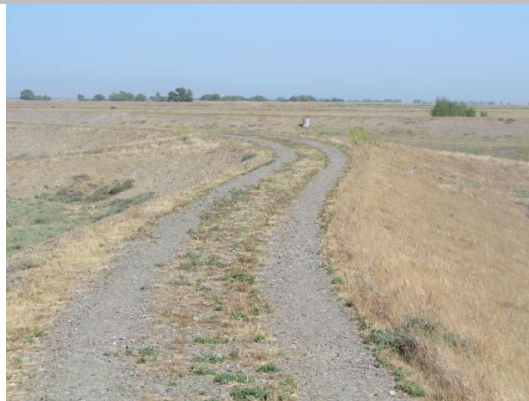
Photo 1 of 1 : richard\_s\_20140519\_815.jpg

Looking west at typical view of levee crown.

LM Start	0.00	Rating **	M	Issue No.	3
LM End	0.81	Issue Type +	Ma	Location *	CR
Category	Earthen Levee			GPS Latitude/Longitude	
				Start	End
Item	Vegetation			37.217944 °	37.219338 °
				-120.711418 °	-120.698026 °
DWR ID	DWR_NA0010_10_s _ 2014_3				
Action/Comments					
Control annual grass and weeds on the levee slopes and easements. Inspector Comments: Control vegetation on levee crown.

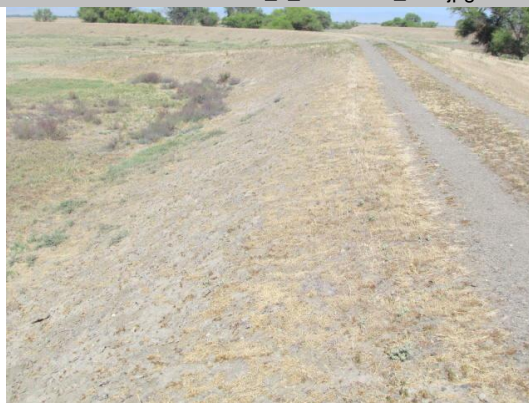
Photo 1 of 1 : richard\_s\_20140519\_816.jpg

Looking at typical view of levee slope.

LM Start	0.00	Rating **	A	Issue No.	1
LM End	0.82	Issue Type +	Ma	Location *	LS
Category	Earthen Levee			GPS Latitude/Longitude	
				Start	End
Item	Vegetation			37.217944 °	37.219331 °
				-120.711418 °	-120.697938 °
DWR ID	DWR_NA0010_10_s _ 2014_1				
Action/Comments					
Control annual grass and weeds on the levee slopes and easements. Inspector Comments: Typical view of landside slope.

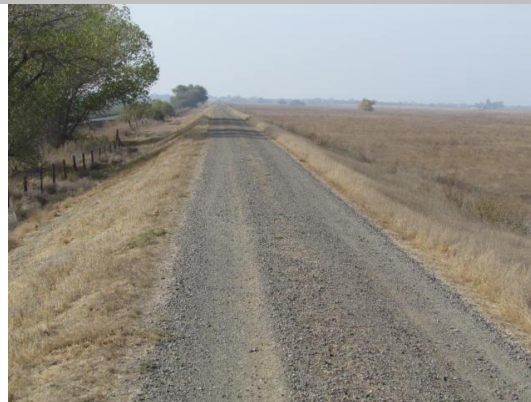
Photo 1 of 1 : richard\_s\_20140417\_630.jpg

Looking west at a properly maintained levee crown. (Fall 2013)

LM Start	0.00	Rating **	A	Issue No.	3
LM End	3.32	Issue Type +	Ma	Location *	LS
Category	Earthen Levee			GPS Latitude/Longitude	
				Start	End
Item	Vegetation			37.200929 °	37.200907 °
				-120.755187 °	-120.711110 °
DWR ID	DWR_NA0010_12_f_2012_3				
Action/Comments					
Control annual grass and weeds on the levee slopes and easements. Inspector Comments: Typical view of vegetation on levee slopes.

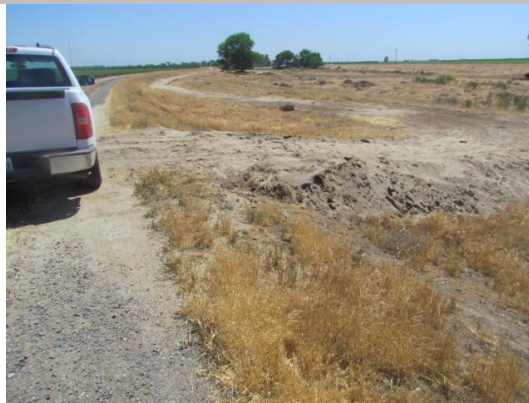
Photo 1 of 2 : richard\_s\_20140520\_818.jpg

LM Start	0.90	Rating **	M	Issue No.	5
LM End	0.90	Issue Type +	En	Location *	WS
Category	Earthen Levee			GPS Latitude/Longitude	
				Start	End
Item	Encroachments			37.044855 °	37.044855 °
				-120.434106 °	-120.434106 °
DWR ID	DWR_NA0010_13_s_2014_5				
Action/Comments					
Ramp					
Inspector Comments: Unauthorized ramp on waterward slope.

Looking east at unauthorized ramp on waterward slope.

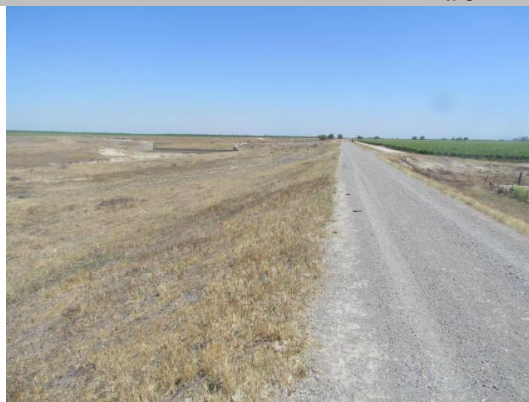
Photo 1 of 1 : richard\_s\_20140520\_820.jpg

Looking west at typical view of levee slopes.

LM Start	0.00	Rating **	M	Issue No.	3
LM End	1.26	Issue Type +	Ma	Location *	WS
Category	Earthen Levee			GPS Latitude/Longitude	
				Start	End
Item	Vegetation			37.032402 °	37.045434 °
				-120.441246 °	-120.427688 °
DWR ID	DWR_NA0010_14_s_2014_3				
Action/Comments					
Control annual grass and weeds on the levee slopes and easements. Inspector Comments: Typical view of levee slopes.

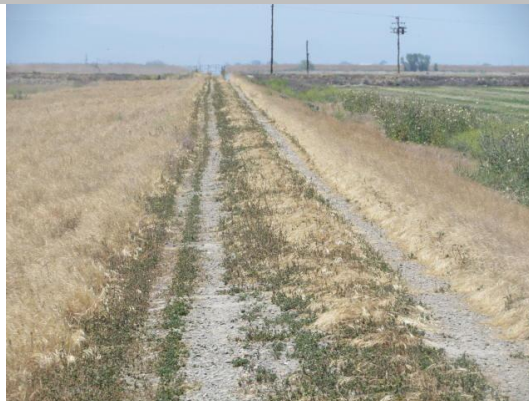
Photo 1 of 1 : richard\_s\_20140520\_822.jpg

Looking east at vegetation on levee crown.

LM Start	0.00	Rating **	M	Issue No.	11
LM End	1.99	Issue Type +	Ma	Location *	CR
Category	Earthen Levee			GPS Latitude/Longitude	
				Start	End
Item	Crown Surface / Depressions / Rutting			36.996547 °	36.996587 °
				-120.410220 °	-120.374503 °
DWR ID	DWR_NA0010_15_s _ 2012_11				
Action/Comments					
Add appropriate material and re-grade the levee to bring the crown above the design elevation.					
Inspector Comments: Control vegetation on levee crown.

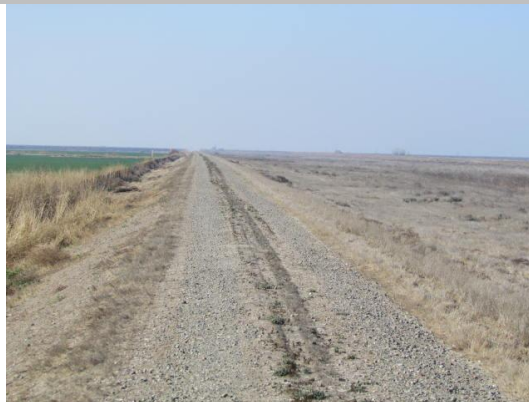
Photo 1 of 1 : richard\_s\_20140417\_632.jpg

LM Start	0.00	Rating **	M	Issue No.	14
LM End	1.98	Issue Type +	Ma	Location *	CR
Category	Earthen Levee			GPS Latitude/Longitude	
				Start	End
Item	Crown Surface / Depressions / Rutting			36.995388 °	36.995507 °
				-120.408738 °	-120.373592 °
DWR ID	DWR_NA0010_16_s _ 2012_14				
Action/Comments					
Add appropriate material and re-grade the levee to bring the crown above the design elevation.					
Inspector Comments: Control vegetation on levee crown.

Looking west at the properly maintained levee crown.

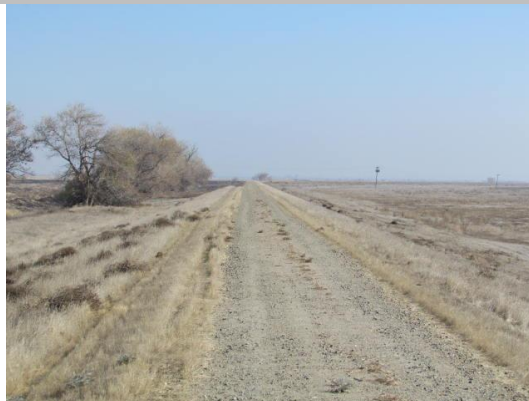
Photo 1 of 1 : richard\_s\_20140417\_633.jpg

LM Start	0.00	Rating **	M	Issue No.	7
LM End	5.77	Issue Type +	Ma	Location *	CR
Category	Earthen Levee			GPS Latitude/Longitude	
				Start	End
Item	Crown Surface / Depressions / Rutting			36.976430 °	36.908282 °
				-120.374748 °	-120.330995 °
DWR ID	DWR_NA0010_17_s _ 2012_7				
Action/Comments					
Add appropriate material and re-grade the levee to bring the crown above the design elevation.

Looking south at vegetation properly maintained on the levee crown.

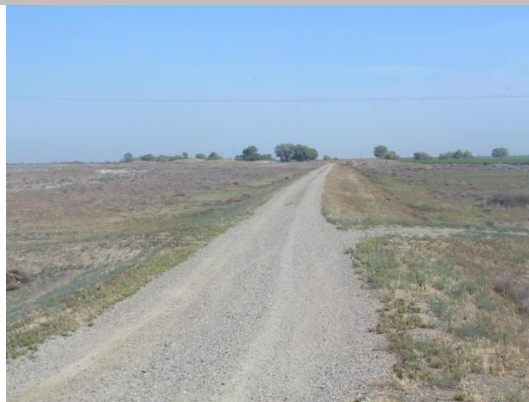
Photo 1 of 1 : richard\_s\_20140520\_826.jpg

LM Start	0.00	Rating **	M	Issue No.	2
LM End	16.09	Issue Type +	Ma	Location *	WS
Category	Earthen Levee			GPS Latitude/Longitude	
				Start	End
Item	Vegetation			36.976441 °	36.774435 °
				-120.374740 °	-120.283773 °
DWR ID	DWR_NA0010_17_s _ 2014_2				
Action/Comments					
Control annual grass and weeds on the levee slopes and easements. Inspector Comments: Typical view of levee

Looking at typical view of levee slopes.

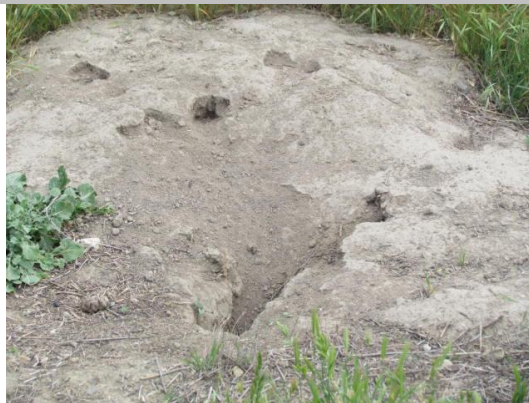
Photo 1 of 1 : richard\_s\_20140417\_634.jpg

LM Start	5.75	Rating **	M	Issue No.	8
LM End	5.90	Issue Type +	Ma	Location *	LS
Category	Earthen Levee			GPS Latitude/Longitude	
				Start	End
Item	Animal Control			36.908605 °	36.906507 °
				-120.331112 °	-120.330353 °
DWR ID	DWR_NA0010_17_s_2012_8				
Action/Comments					
Exterminate rodents and backfill and compact or grout burrows.

Looking at several rodent holes on landside slope.

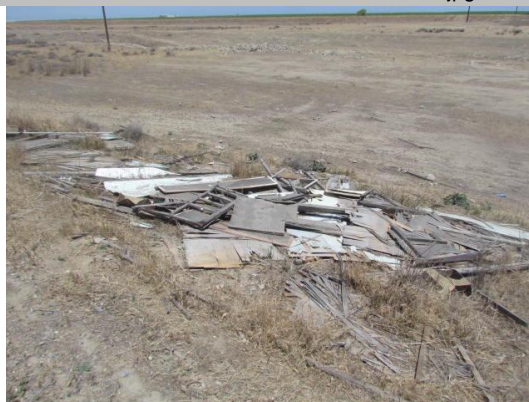
Photo 1 of 1 : richard\_s\_20140520\_827.jpg

LM Start	8.04	Rating **	M	Issue No.	5
LM End	8.04	Issue Type +	En	Location *	WS
Category	Earthen Levee			GPS Latitude/Longitude	
				Start	End
Item	Encroachments			36.865074 °	36.865074 °
				-120.317996 °	-120.317996 °
DWR ID	DWR_NA0010_18_s _ 2014_5				
Action/Comments					
Garbage Inspector Comments: Trash on waterward slope.

Looking west at trash on waterward slope.

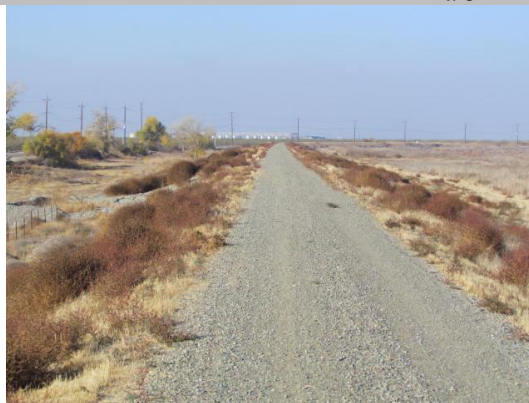
Photo 1 of 1 : richard\_s\_20140417\_635.jpg

LM Start	11.86	Rating **	A/W	Issue No.	1
LM End	13.15	Issue Type +	Ma	Location *	LS
Category	Earthen Levee			GPS Latitude/Longitude	
				Start	End
Item	Vegetation			36.815400 °	36.797353 °
				-120.305080 °	-120.308560 °
DWR ID	DWR_NA0010_18_s _ 2012_1				
Action/Comments					
Remove the wild growth other than native grasses from the levee slopes. Inspector Comments: Dense tumble weed on landside and waterside shoulder and slope.

Looking north at controlled tumble weeds on landward and waterward slope. (Fall 2013)

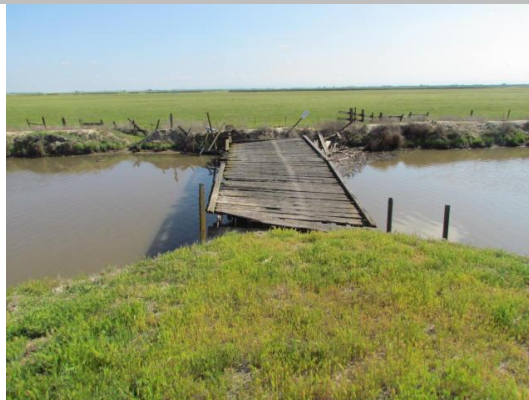
Photo 1 of 2 : richard\_s\_20140417\_638.jpg

LM Start	4.68	Rating **	M	Issue No.	3
LM End	4.68	Issue Type +	En	Location *	WS
Category	Channels			GPS Latitude/Longitude	
				Start	End
Item	Encroachments			37.264250 °	37.264250 °
				-120.731280 °	-120.731280 °
DWR ID	DWR_NA0010_22A_s_2012_3				
Action/Comments					
Inspector Comments: Old wooden bridge in channel should be removed.

Looking east at dilapidated bridge across canal.

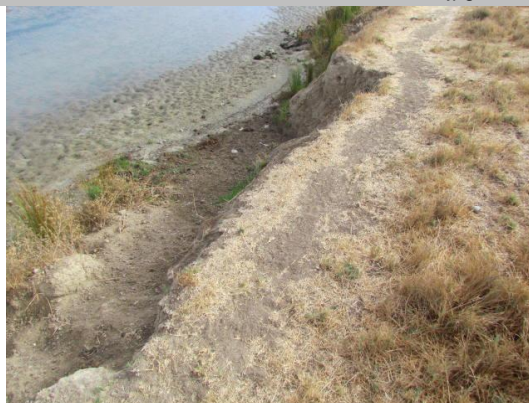
Photo 2 of 2 : richard\_s\_20140417\_641.jpg

LM Start	5.05	Rating **	M	Issue No.	4
LM End	5.05	Issue Type +	Ma	Location *	WS
Category	Earthen Levee			GPS Latitude/Longitude	
				Start	End
Item	Erosion / Bank Caving			37.267516 °	37.267516 °
				-120.736401 °	-120.736401 °
DWR ID	DWR_NA0010_22A_f_2013_4				
Action/Comments					
Schedule repair of erosion site prior to the next inspection. Inspector Comments: Erosion caused by animal traffic.

LM Start	<b>5.05</b>	Rating **	M	Issue No.	<b>4 (cont)</b>
LM End	<b>5.05</b>	Issue Type +	Ma	Location *	WS

Looking southeast at livestock erosion on waterward toe.

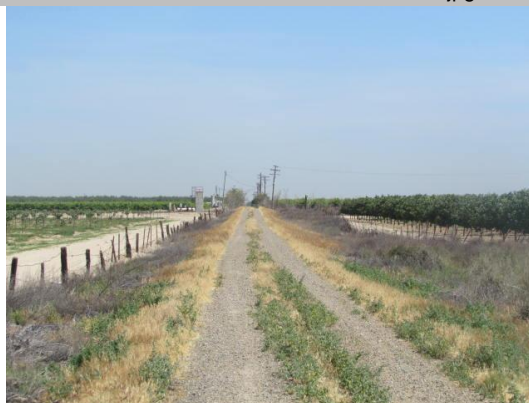
Photo 1 of 1 : richard\_s\_20140520\_828.jpg

LM Start	0.00	Rating **	M	Issue No.	4
LM End	10.25	Issue Type +	Ma	Location *	LS
Category	Earthen Levee			GPS Latitude/Longitude	
				Start	End
Item	Vegetation			36.774369 °	36.814835 °
				-120.283704 °	-120.168888 °
DWR ID	DWR_NA0010_23_s _ 2014_4				
Action/Comments					
Control annual grass and weeds on the levee slopes and easements.

Looking at typical view of vegetation on levee crown and slopes.

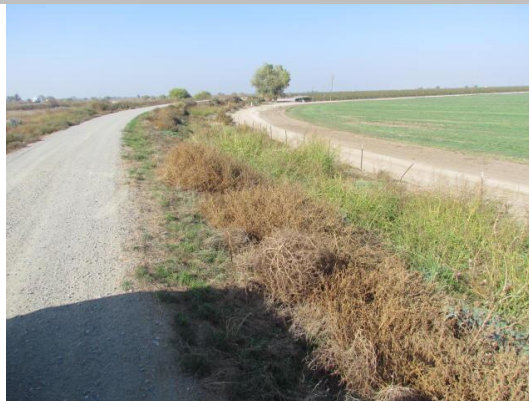
Photo 1 of 2 : richard\_s\_20140417\_649.jpg

LM Start	1.56	Rating **	A/W	Issue No.	2
LM End	1.75	Issue Type +	Ma	Location *	LS
Category	Earthen Levee			GPS Latitude/Longitude	
				Start	End
Item	Vegetation			36.771778 °	36.771625 °
				-120.259143 °	-120.255817 °
DWR ID	DWR_NA0010_23_s_2012_2				
Action/Comments					
Remove the wild growth other than native grasses from the levee

Looking south at dense vegetation on landside slope.

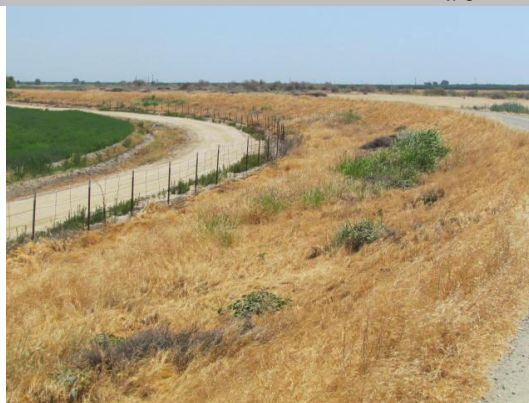
Photo 2 of 2 : richard\_s\_20140417\_650.jpg

LM Start	<b>1.56</b>	Rating **	A/W	Issue No.	<b>2 (cont)</b>
LM End	<b>1.75</b>	Issue Type +	Ma	Location *	LS

Looking south at typical view of landward slope.

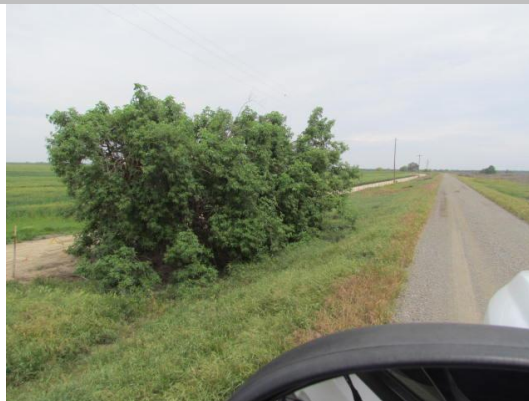
Photo 1 of 1 : richard\_s\_20140417\_662.jpg

LM Start	2.85	Rating **	M	Issue No.	15
LM End	2.85	Issue Type +	Ma	Location *	LS
Category	Earthen Levee			GPS Latitude/Longitude	
				Start	End
Item	Vegetation			36.771537 °	36.771537 °
				-120.240917 °	-120.240917 °
DWR ID	DWR_NA0010_23_s _ 2012_15				
Action/Comments					
Elderberries are blocking visibility and flood fight capability.

Looking south at elderberry on landside toe and berm.

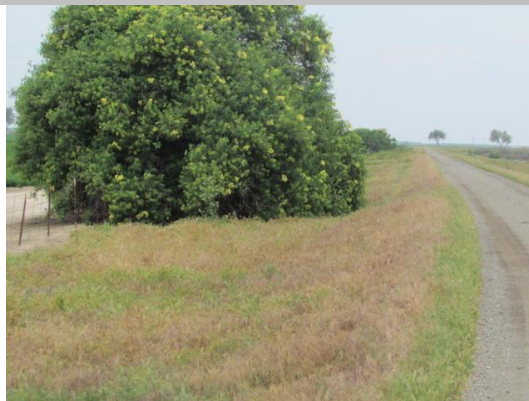
Photo 1 of 2 : richard\_s\_20140417\_651.jpg

LM Start	3.30	Rating **	M	Issue No.	3
LM End	3.30	Issue Type +	Ma	Location *	LS
Category	Earthen Levee			GPS Latitude/Longitude	
				Start	End
Item	Vegetation			36.774403 °	36.774403 °
				-120.234705 °	-120.234705 °
DWR ID	DWR_NA0010_23_s _ 2012_3				
Action/Comments					
Elderberries are blocking visibility and flood fight capability.

Looking south at elderberry on landside toe and berm.

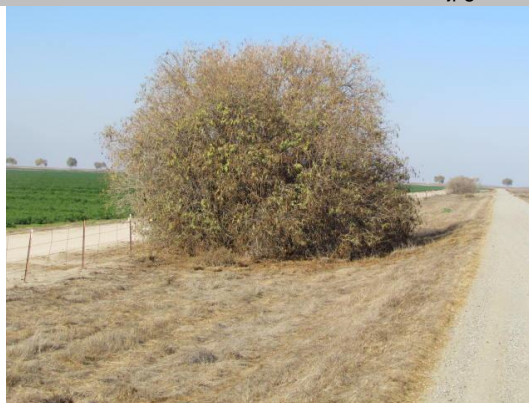
Photo 2 of 2 : richard\_s\_20140417\_652.jpg

LM Start	<b>3.30</b>	Rating **	M	Issue No.	<b>3 (cont)</b>
LM End	<b>3.30</b>	Issue Type +	Ma	Location *	LS

Looking south at elderberry bush on landward toe. (Fall 2013)

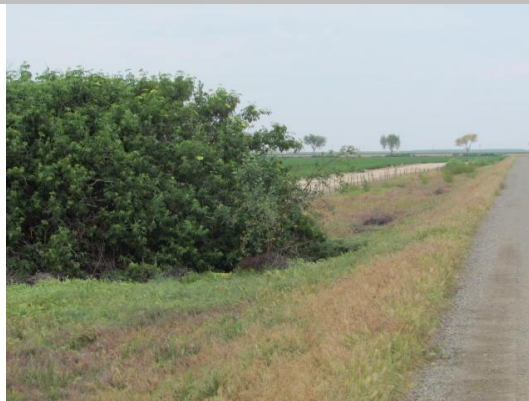
Photo 1 of 1 : richard\_s\_20140417\_656.jpg

LM Start	3.45	Rating **	M	Issue No.	9
LM End	3.45	Issue Type +	Ma	Location *	LS
Category	Earthen Levee			GPS Latitude/Longitude	
				Start	End
Item	Vegetation			36.776537 °	36.776537 °
				-120.234573 °	-120.234573 °
DWR ID	DWR_NA0010_23_s _ 2012_9				
Action/Comments					
Elderberries are blocking visibility and flood fight capability.

Looking south at elderberry on landside toe and berm.

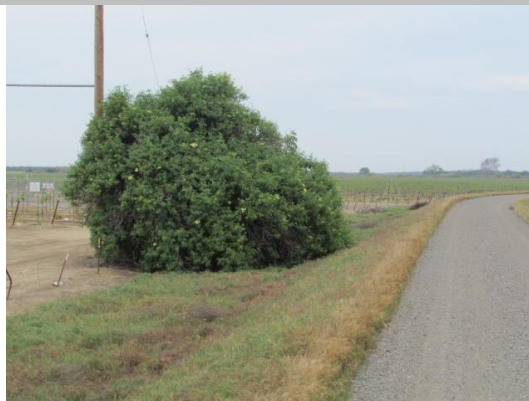
Photo 1 of 2 : richard\_s\_20140417\_657.jpg

LM Start	4.14	Rating **	M	Issue No.	10
LM End	4.14	Issue Type +	Ma	Location *	LS
Category	Earthen Levee			GPS Latitude/Longitude	
				Start	End
Item	Vegetation			36.784212 °	36.784212 °
				-120.228815 °	-120.228815 °
DWR ID	DWR_NA0010_23_s _ 2012_10				
Action/Comments					
Elderberries are blocking visibility and flood fight capability.

Looking south at elderberry on landside toe and berm.
