**Flood Control Project Maintenance  
Levee Inspections**  
**LMA District Cover Sheet**  
**Spring 2014 Levee Inspection Results**

**Lower San Joaquin Levee District**

**Spring 2014 Levee Inspection Results**

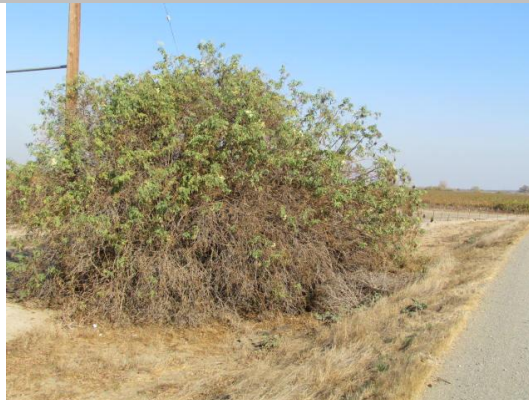
Photo 2 of 2 : richard\_s\_20140417\_658.jpg

LM Start	<b>4.14</b>	Rating **	M	Issue No.	<b>10 (cont)</b>
LM End	<b>4.14</b>	Issue Type +	Ma	Location *	LS

Looking south at elderberry bush on landward toe. (Fall 2013)

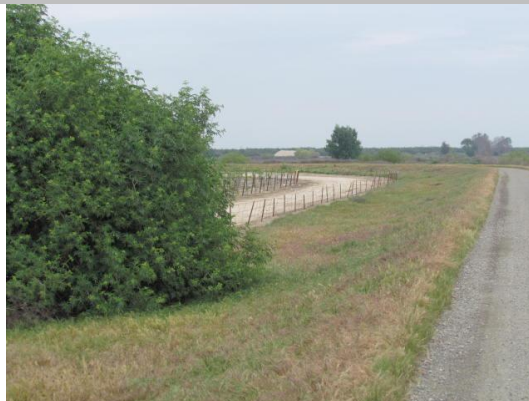
Photo 1 of 1 : richard\_s\_20140417\_659.jpg

LM Start	4.46	Rating **	M	Issue No.	11
LM End	4.46	Issue Type +	Ma	Location *	LS
Category	Earthen Levee			GPS Latitude/Longitude	
				Start	End
Item	Vegetation			36.784523 °	36.784523 °
				-120.223292 °	-120.223292 °
DWR ID	DWR_NA0010_23_s_2012_11				
Action/Comments					
Elderberries are blocking visibility and flood fight capability.

Looking south at elderberry on landside toe and berm.

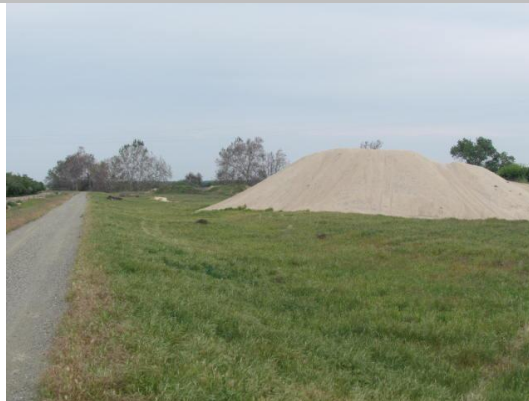
Photo 1 of 2 : richard\_s\_20140417\_654.jpg

LM Start	5.23	Rating **	A/W	Issue No.	7
LM End	5.23	Issue Type +	Ma	Location *	WS
Category	Earthen Levee			GPS Latitude/Longitude	
				Start	End
Item	Encroachments			36.791400 °	36.791400 °
				-120.214222 °	-120.214222 °
DWR ID	DWR_NA0010_23_s_2012_7				
Action/Comments					
Material					
Inspector Comments: Sand pile in levee channel over three feet high.					
Pile is too close to levee.

Looking south at sand pile 20-30 feet away from waterside slope.

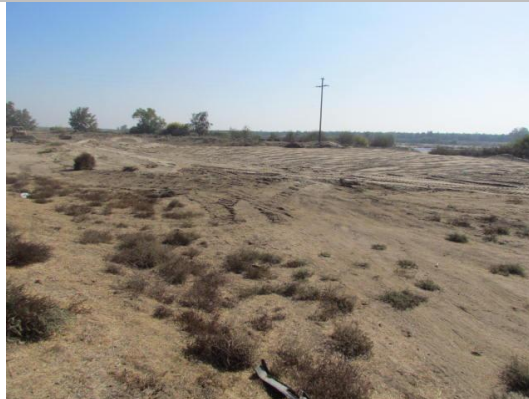
Photo 2 of 2 : richard\_s\_20140417\_655.jpg

LM Start	<b>5.23</b>	Rating **	A/W	Issue No.	<b>7 (cont)</b>
LM End	<b>5.23</b>	Issue Type +	Ma	Location *	WS

Looking southwest at de-graded sandpile in channel.

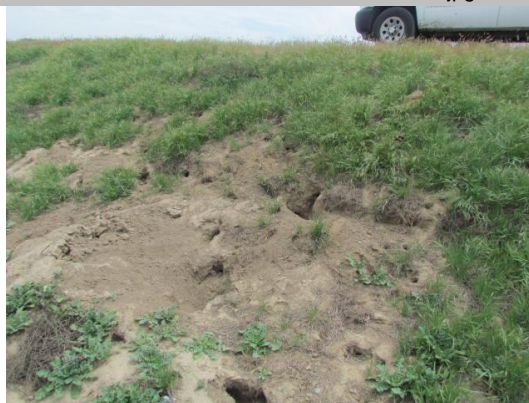
Photo 1 of 1 : richard\_s\_20140417\_653.jpg

LM Start	5.69	Rating **	M	Issue No.	5
LM End	5.90	Issue Type +	Ma	Location *	WS
Category	Earthen Levee			GPS Latitude/Longitude	
				Start	End
Item	Animal Control			36.792012 °	36.790972 °
				-120.206270 °	-120.202588 °
DWR ID	DWR_NA0010_23_s _ 2012_5				
Action/Comments					
Exterminate rodents and backfill and compact or grout burrows.

Looking at several rodent holes on landside slope.

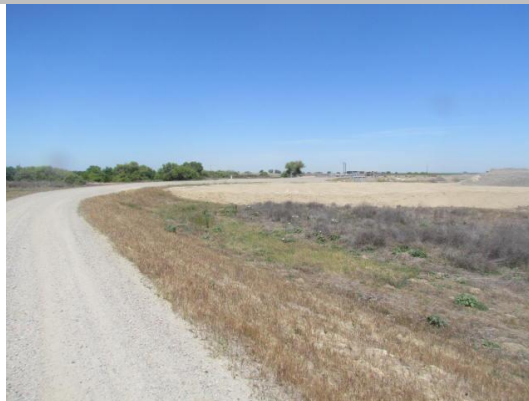
Photo 1 of 2 : richard\_s\_20140520\_829.jpg

LM Start	0.06	Rating **	M	Issue No.	47
LM End	0.06	Issue Type +	En	Location *	LS
Category	Earthen Levee			GPS Latitude/Longitude	
				Start	End
Item	Encroachments			36.772328 °	36.772328 °
				-120.285117 °	-120.285117 °
DWR ID	DWR_NA0010_24_s _ 2014_47				
Action/Comments					
Material					
Inspector Comments: District constructed a berm on waterward slope. Berm is being used for staging of earthen material.

Looking north at berm on waterward slope.

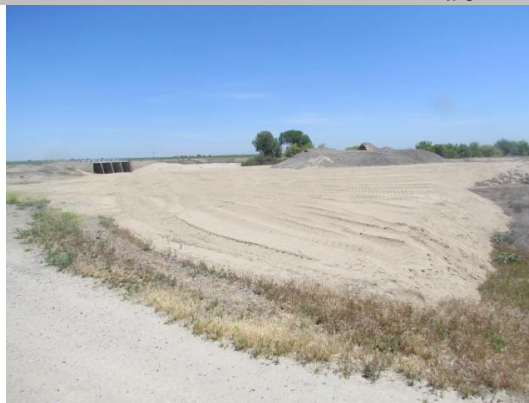
Photo 2 of 2 : richard\_s\_20140520\_830.jpg

LM Start	<b>0.06</b>	Rating **	M	Issue No.	<b>47 (cont)</b>
LM End	<b>0.06</b>	Issue Type +	En	Location *	LS

Looking south at berm on waterward slope.

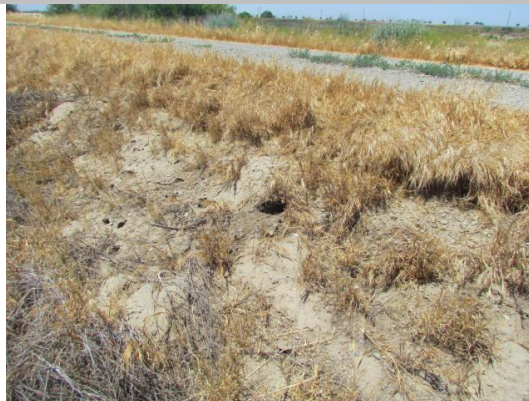
Photo 1 of 1 : richard\_s\_20140417\_666.jpg

LM Start	3.46	Rating **	M	Issue No.	7
LM End	3.46	Issue Type +	Ma	Location *	LS
Category	Earthen Levee			GPS Latitude/Longitude	
				Start	End
Item	Animal Control			36.769345 °	36.769345 °
				-120.238370 °	-120.238370 °
DWR ID	DWR_NA0010_24_s_2012_7				
Action/Comments					
No rodents visible, but rodent burrows visible; need to backfill and compact or grout burrows. Inspector Comments: One of several rodent holes on landward slope.

Looking east at one of several rodent holes on landward slope.

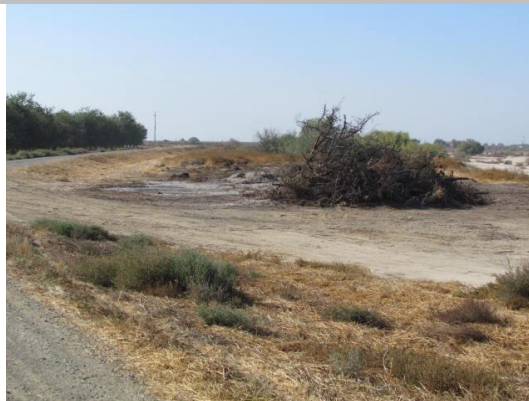
Photo 1 of 1 : richard\_s\_20140417\_665.jpg

LM Start	6.33	Rating **	M	Issue No.	3
LM End	6.33	Issue Type +	En	Location *	WS
Category	Earthen Levee			GPS Latitude/Longitude	
				Start	End
Item	Encroachments			36.788155 °	36.788155 °
				-120.209655 °	-120.209655 °
DWR ID	DWR_NA0010_24_s_2012_3				
Action/Comments					
Prunings					
Inspector Comments: Pruning pile in channel.

Looking north at prunings on waterside berm.

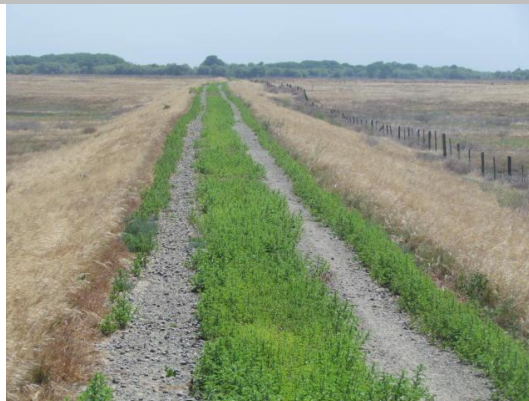
Photo 1 of 1 : richard\_s\_20140520\_845.jpg

LM Start	0.00	Rating **	M	Issue No.	8
LM End	2.47	Issue Type +	Ma	Location *	CR
Category	Earthen Levee			GPS Latitude/Longitude	
				Start	End
Item	Crown Surface / Depressions / Rutting			37.296117 °	37.271193 °
				-120.880724 °	-120.866633 °
DWR ID	DWR_NA0010_25_s _ 2012_8				
Action/Comments					
Add appropriate material and re-grade the levee to bring the crown above the design elevation.					
Inspector Comments: Control weeds on levee crown.

Looking north at typical view of vegetation on levee crown.
