**Flood Control Project Maintenance
Levee Inspections****LMA District Cover Sheet****Spring 2015 Levee Inspection Results****Lower San Joaquin Levee District**

Spring 2015 Levee Inspection Results

Lower San Joaquin Levee District

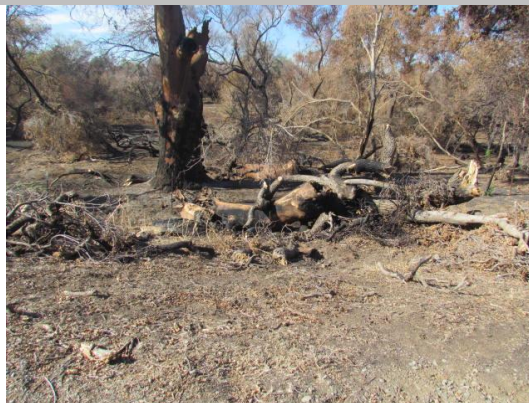
Photo 1 of 2 : SP_2015_NA0010_118_98_20150309_00012.jpg

LM Start	0.06	Rating **	A/W	Issue No.	98
LM End	0.06	Issue Type +	Ma	Location *	WS
Category	Earthen Levee			GPS Latitude/Longitude	
				Start	End
Item	Encroachments			37.348157 °	37.348157 °
				-120.959658 °	-120.959658 °
DWR ID	DWR_NA0010_01_f_2014_98				
Action/Comments					
Tree or limb					
Inspector Comments: Downed tree limbs due to fire along levee slope.

Looking southwest at tree limbs on waterward toe.

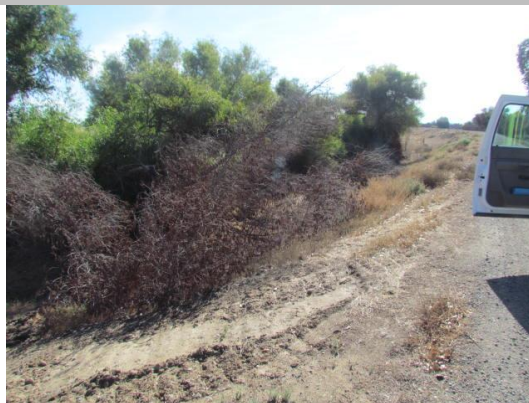
Photo 1 of 1 : SP_2015_NA0010_118_99_20150309_00014.jpg

LM Start	0.19	Rating **	A/W	Issue No.	99
LM End	0.19	Issue Type +	Ma	Location *	LS
Category	Earthen Levee			GPS Latitude/Longitude	
				Start	End
Item	Encroachments			37.346582 °	37.346582 °
				-120.961052 °	-120.961052 °
DWR ID	DWR_NA0010_01_f _ 2014_99				
Action/Comments					
Tree or limb					
Inspector Comments: Downed tree limbs on landward slope.

Looking south at tree limbs on landward slope and toe.

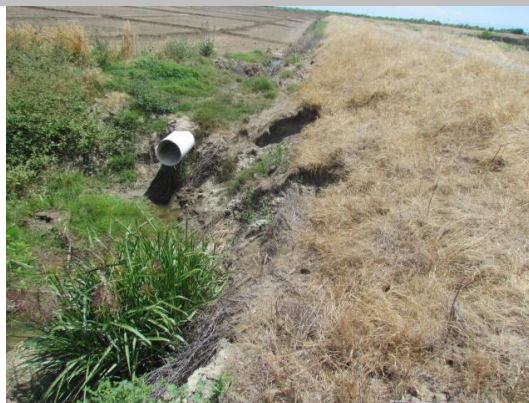
Photo 1 of 3 : SP_2015_NA0010_118_1179_20150527_00181.jpg

LM Start	3.47	Rating **	U	Issue No.	1179
LM End	3.47	Issue Type +	Ma	Location *	LS
Category	Earthen Levee			GPS Latitude/Longitude	
				Start	End
Item	Erosion / Bank Caving			37.317057 °	37.317057 °
				-120.926443 °	-120.926443 °
DWR ID	DWR_NA0010_01_s_2015_1179				
Action/Comments					
Note and monitor erosion site. Inspector Comments: Several erosions greater than three inches on landward slope.

Looking south at erosion on landward slope and toe.

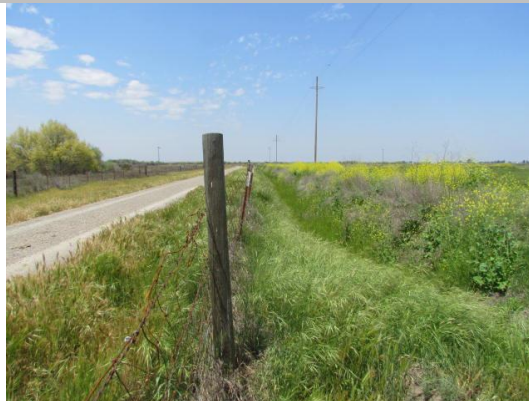
Photo 1 of 2 : SP_2015_NA0010_118_5_20150309_00002.jpg

LM Start	3.98	Rating **	M	Issue No.	5
LM End	4.05	Issue Type +	En	Location *	LS
Category	Earthen Levee			GPS Latitude/Longitude	
				Start	End
Item	Encroachments			37.310837 °	37.310003 °
				-120.926182 °	-120.925313 °
DWR ID	DWR_NA0010_01_s _ 2012_5				
Action/Comments					
Ditch					
Inspector Comments: Irrigation ditch at landside toe

Looking north at irrigation ditch at landside toe.

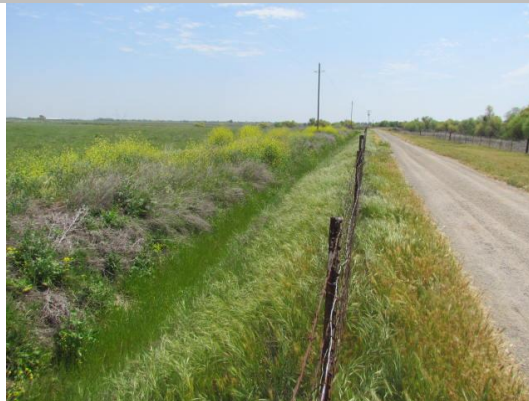
Photo 2 of 2 : SP_2015_NA0010_118_5_20150309_00003.jpg

Looking south at irrigation ditch at landside toe.

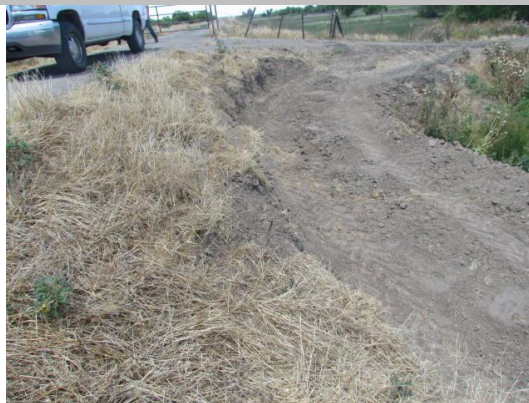
Photo 1 of 3 : SP_2015_NA0010_118_9_20150527_00185.jpg

Looking northeast at corrected site on landward slope.

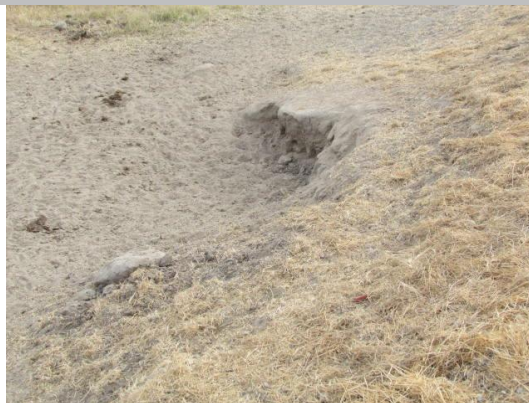
Photo 2 of 3 : SP_2015_NA0010_118_9_20150309_00005.jpg

Looking southeast at erosion on landward toe.

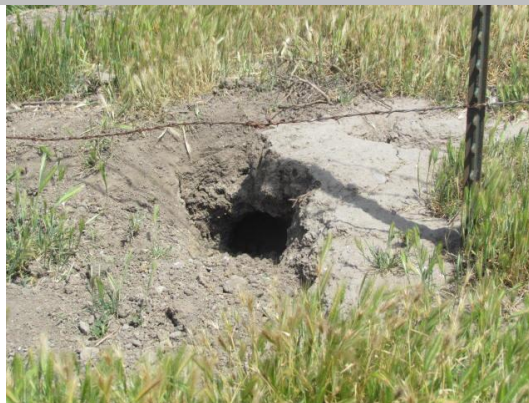
Photo 1 of 3 : SP_2015_NA0010_118_116_20150309_00016.jpg

LM Start	5.72	Rating **	A/W	Issue No.	116
LM End	5.72	Issue Type +	Ma	Location *	LS
Category	Earthen Levee			GPS Latitude/Longitude	
				Start	End
Item	Animal Control			37.304057 °	37.304057 °
				-120.907200 °	-120.907200 °
DWR ID	DWR_NA0010_01_s_2012_116				
Action/Comments					
No rodents visible, but rodent burrows visible; need to backfill and compact or grout burrows. Inspector Comments: Large rodent holes on landside slope near fence pole.

Looking east at one of several rodent holes on landside shoulder and slope.

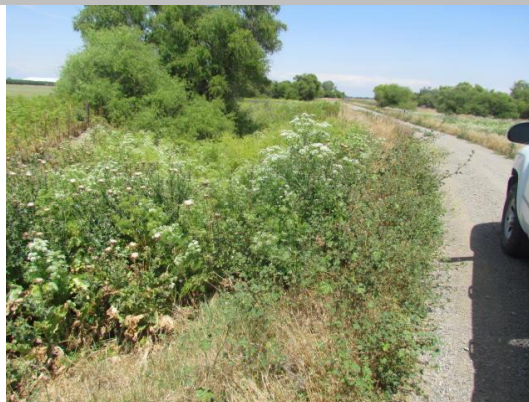
Photo 1 of 1 : SP_2015_NA0010_118_12_20150527_00186.jpg

LM Start	6.01	Rating **	U	Issue No.	12
LM End	6.01	Issue Type +	Ma	Location *	LS
Category	Earthen Levee			GPS Latitude/Longitude	
				Start	End
Item	Vegetation			37.303725 °	37.303725 °
				-120.902003 °	-120.902003 °
DWR ID	DWR_NA0010_01_s _ 2012_12				
Action/Comments					
Remove the wild growth other than native grasses from the levee slopes.

Looking south at dense vegetation on landward slope.

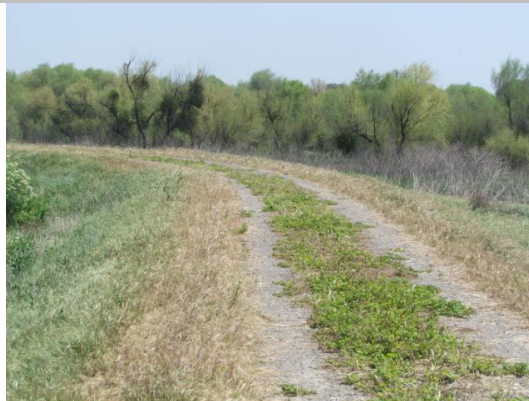
Photo 1 of 3 : SP_2015_NA0010_118_117_20150309_00019.jpg

LM Start	9.16	Rating **	M	Issue No.	117
LM End	9.78	Issue Type +	Ma	Location *	CR
Category	Earthen Levee			GPS Latitude/Longitude	
				Start	End
Item	Crown Surface / Depressions / Rutting			37.296145 °	37.293077 °
				-120.848588 °	-120.839170 °
DWR ID	DWR_NA0010_01_s _ 2012_117				
Action/Comments					
Add appropriate material and re-grade the levee to bring the crown above the design elevation.					
Inspector Comments: Control vegetation on levee crown.

Looking south at typical view of vegetation on levee crown.

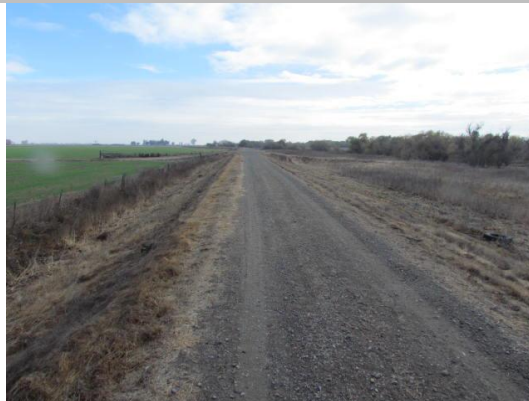
Photo 2 of 3 : SP_2015_NA0010_118_117_20150309_00020.jpg

Looking south at levee crown. (Fall 2013)

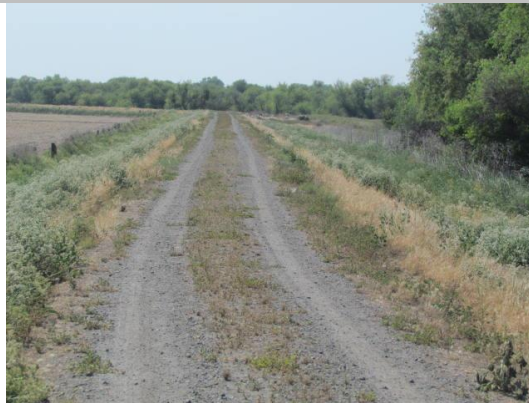
Photo 3 of 3 : SP_2015_NA0010_118_117_20150309_00021.jpg

Looking south at vegetation on levee crown. (Spring 2013)

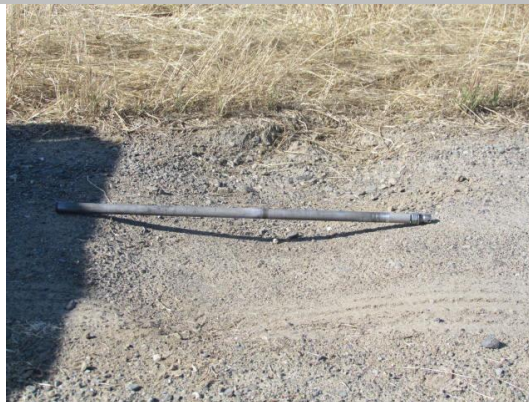
Photo 2 of 2 : SP_2015_NA0010_118_14_20150527_00187.jpg

Looking west at depression on levee crown.

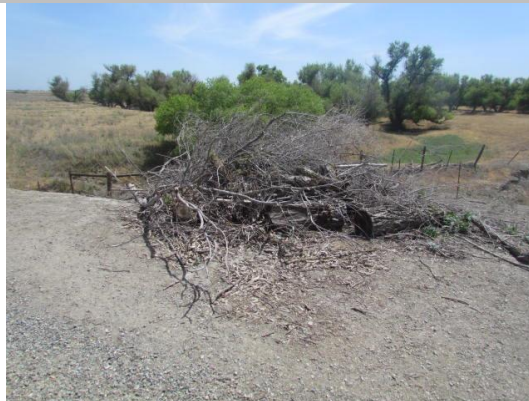
Photo 1 of 1 : SP_2015_NA0010_118_27_20150309_00011.jpg

LM Start	18.77	Rating **	M	Issue No.	27
LM End	18.77	Issue Type +	En	Location *	WS
Category	Earthen Levee			GPS Latitude/Longitude	
				Start	End
Item	Encroachments			37.205080 °	37.205080 °
				-120.762655 °	-120.762655 °
DWR ID	DWR_NA0010_01_s _ 2014_27				
Action/Comments					
Prunings

Looking at prunings on waterward shoulder and slope.

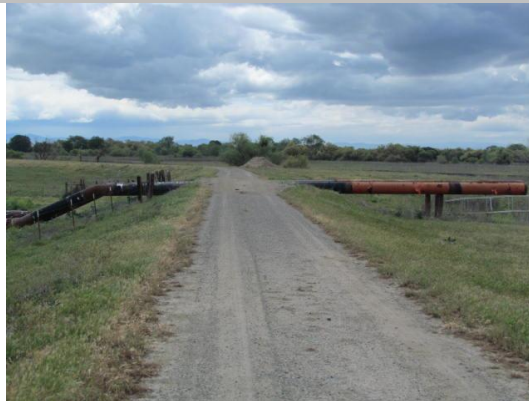
Photo 1 of 1 : SP_2015_NA0010_118_8_20150309_00004.jpg

LM Start	19.32	Rating **	M	Issue No.	8
LM End	19.32	Issue Type +	Ma	Location *	CR
Category	Earthen Levee			GPS Latitude/Longitude	
				Start	End
Item	Encroachments			37.200923 °	37.200923 °
				-120.756987 °	-120.756987 °
DWR ID	DWR_NA0010_01_s_2012_8				
Action/Comments					
Pipe					
Inspector Comments: Farmer installed a pipe across levee crown, landside and waterside slopes. Ramp is not according to standards.

Looking south at pipe across levee crown.

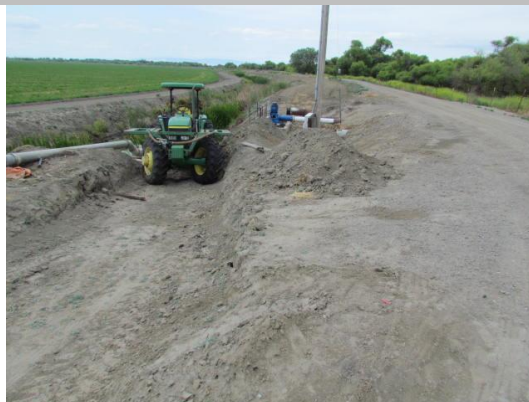
Photo 1 of 2 : SP_2015_NA0010_118_1184_20150527_00189.jpg

LM Start	20.25	Rating **	U	Issue No.	1184
LM End	20.25	Issue Type +	En	Location *	LS
Category	Earthen Levee			GPS Latitude/Longitude	
				Start	End
Item	Encroachments			37.193657 °	37.193657 °
				-120.760138 °	-120.760138 °
DWR ID	DWR_NA0010_01_s _ 2015_1184				
Action/Comments					
Ramp Inspector Comments: Landowner installed unauthorized ramp on landward slope and toe.

Looking north at ramp cut into landward slope.

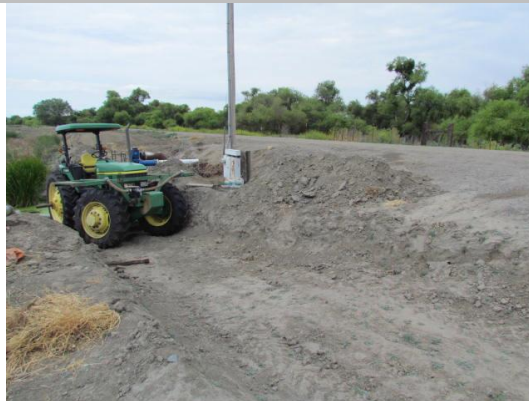
Photo 2 of 2 : SP_2015_NA0010_118_1184_20150527_00190.jpg

LM Start	20.25	Rating **	U	Issue No.	1184 (cont)	
LM End	20.25	Issue Type +	En	Location *	LS	
Category	Earthen Levee			GPS Latitude/Longitude		
				Start		End
Item	Encroachments			37.193657 °	37.193657 °	
				-120.760138 °	-120.760138 °	
DWR ID	DWR_NA0010_01_s_2015_1184					
Action/Comments						
Ramp Inspector Comments: Landowner installed unauthorized ramp on landward slope and toe.

Looking east at ramp cut into landward slope.

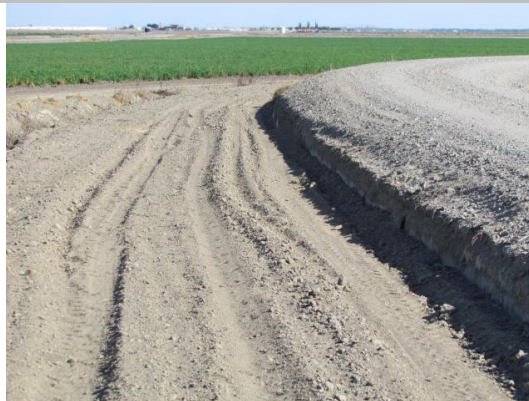
Photo 2 of 2 : SP_2015_NA0010_118_20_20150309_00008.jpg

LM Start	20.28	Rating **	M	Issue No.	20 (cont)
LM End	22.01	Issue Type +	En	Location *	LS
Category	Earthen Levee			GPS Latitude/Longitude	
				Start	End
Item	Encroachments			37.193426 °	37.172663 °
				-120.760419 °	-120.754894 °
DWR ID	DWR_NA0010_01_f_2012_20				
Action/Comments					
Agricultural tilling					
Inspector Comments: Farmer cutting into landside toe and slope.

Looking west at farmer discing landside slope.

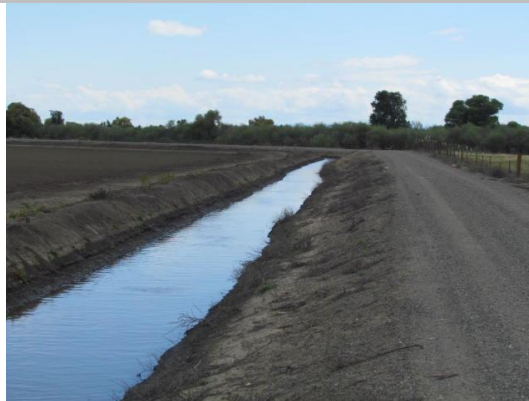
Photo 2 of 2 : SP_2015_NA0010_118_22_20150309_00010.jpg

LM Start	22.20	Rating **	M	Issue No.	22 (cont)
LM End	22.51	Issue Type +	En	Location *	LS
Category	Earthen Levee			GPS Latitude/Longitude	
				Start	End
Item	Encroachments			37.169962 °	37.166983 °
				-120.754240 °	-120.750127 °
DWR ID	DWR_NA0010_01_s _ 2012_22				
Action/Comments					
Ditch

Looking upstream at irrigation at landside toe.

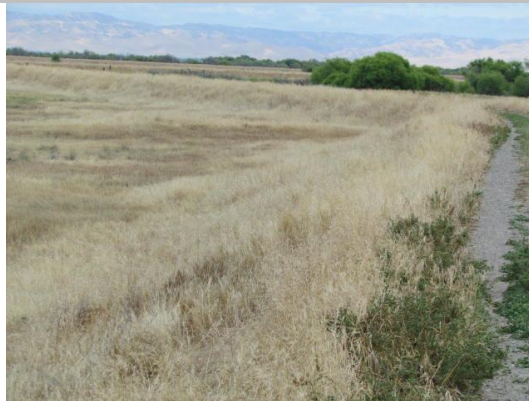
Photo 1 of 1 : SP_2015_NA0010_119_250_20150527_00006.jpg

LM Start	0.00	Rating **	M	Issue No.	250
LM End	7.84	Issue Type +	Ma	Location *	LS
Category	Earthen Levee			GPS Latitude/Longitude	
				Start	End
Item	Vegetation			37.296314 °	37.231606 °
				-120.880559 °	-120.812192 °
DWR ID	DWR_NA0010_02A_s_2015_250				
Action/Comments					
Control annual grass and weeds on the levee slopes and easements.

Looking west at typical view of landward slope.

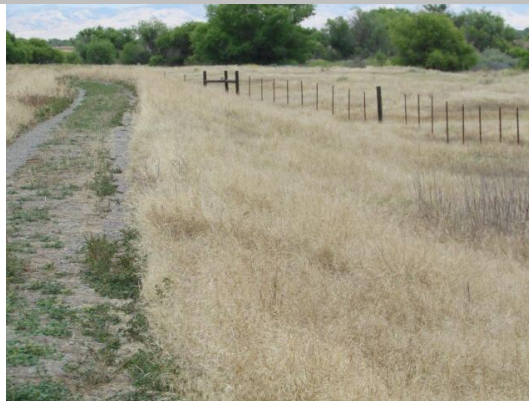
Photo 1 of 1 : SP_2015_NA0010_119_251_20150527_00007.jpg

LM Start	0.00	Rating **	M	Issue No.	251
LM End	7.84	Issue Type +	Ma	Location *	WS
Category	Earthen Levee			GPS Latitude/Longitude	
				Start	End
Item	Vegetation			37.296314 °	37.231601 °
				-120.880559 °	-120.812191 °
DWR ID	DWR_NA0010_02A_s_2015_251				
Action/Comments					
Control annual grass and weeds on the levee slopes and easements.

Looking northwest at typical view of waterward slope.

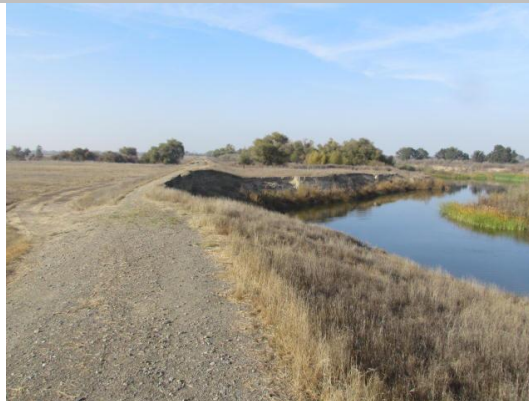
Photo 1 of 3 : SP_2015_NA0010_119_5_20150309_00003.jpg

LM Start	0.75	Rating **	U	Issue No.	5
LM End	0.75	Issue Type +	Ma	Location *	WS
Category	Earthen Levee			GPS Latitude/Longitude	
				Start	End
Item	Erosion / Bank Caving			37.286877 °	37.286877 °
				-120.874222 °	-120.874222 °
DWR ID	DWR_NA0010_02A_s_2012_5				
Action/Comments					
Schedule repair of erosion site prior to the next inspection. Inspector Comments: A field investigation report in on file. For more information and pictures see field investigation report #4301.

Looking north at erosion on waterward slope. (Fall 2014)

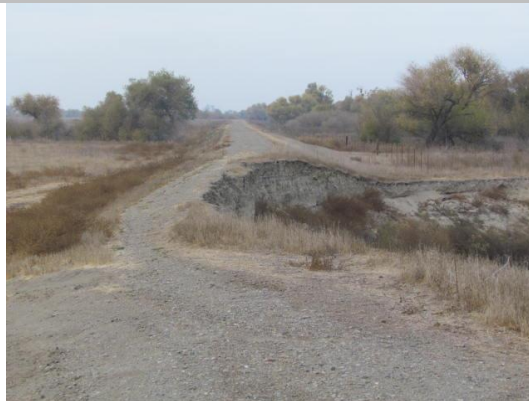
Photo 2 of 3 : SP_2015_NA0010_119_5_20150309_00004.jpg

Looking north at large erosion on waterward slope. (Fall 2013)

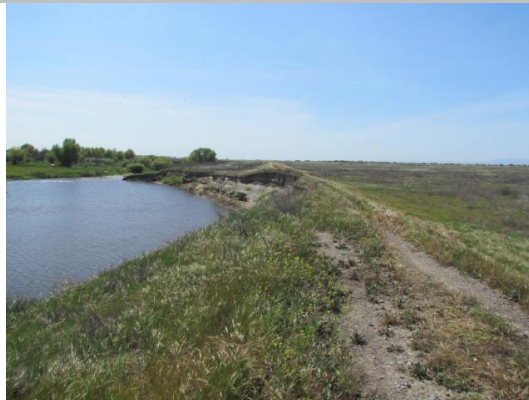
Photo 3 of 3 : SP_2015_NA0010_119_5_20150309_00005.jpg

Looking south at large erosion on waterside slope. (Spring 2012)

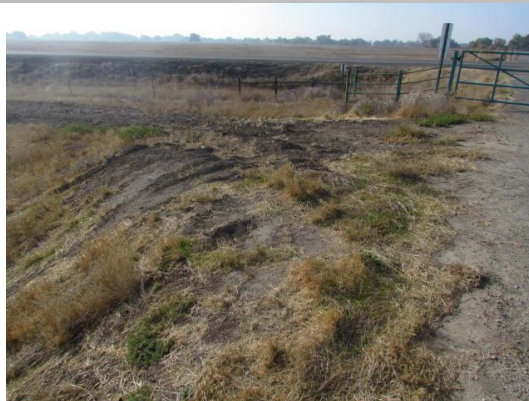
Photo 2 of 2 : SP_2015_NA0010_119_2_20150309_00002.jpg

LM Start	2.32	Rating **	M	Issue No.	2 (cont)
LM End	2.32	Issue Type +	En	Location *	LS
Category	Earthen Levee			GPS Latitude/Longitude	
				Start	End
Item	Encroachments			37.291433 °	37.291433 °
				-120.850917 °	-120.850917 °
DWR ID	DWR_NA0010_02A_s_2012_2				
Action/Comments					
Ramp Inspector Comments: Unauthorized ramp on landside and waterside slope.

Looking northwest at unauthorized ramp on waterward slope.

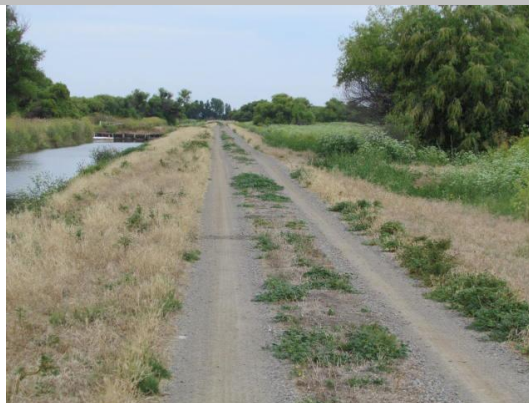
Photo 1 of 1 : SP_2015_NA0010_120_168_20150527_00006.jpg

LM Start	7.87	Rating **	M	Issue No.	168
LM End	13.22	Issue Type +	Ma	Location *	CR
Category	Earthen Levee			GPS Latitude/Longitude	
				Start	End
Item	Vegetation			37.231604 °	37.178622 °
				-120.812190 °	-120.764448 °
DWR ID	DWR_NA0010_02B_s_2015_168				
Action/Comments					
Control annual grass and weeds on the levee slopes and easements. Inspector Comments: Control vegetation on levee crown.

Looking north at typical view of levee crown.

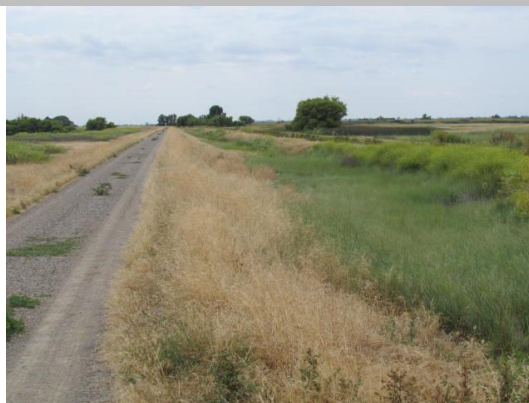
Photo 1 of 1 : SP_2015_NA0010_120_169_20150527_00008.jpg

LM Start	7.87	Rating **	M	Issue No.	169
LM End	13.79	Issue Type +	Ma	Location *	LS
Category	Earthen Levee			GPS Latitude/Longitude	
				Start	End
Item	Vegetation			37.231604 °	°
				-120.812190 °	°
DWR ID	DWR_NA0010_02B_s_2015_169				
Action/Comments					
Control annual grass and weeds on the levee slopes and easements.

Looking northwest at typical view of waterward slope.

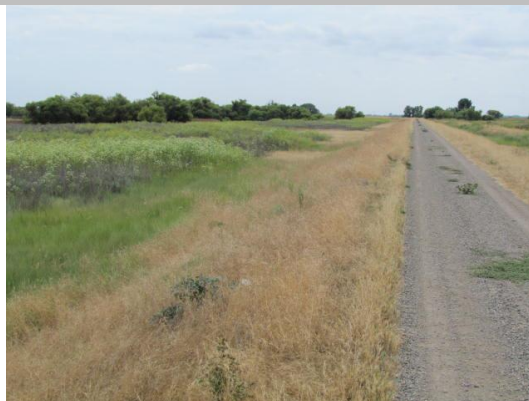
Photo 1 of 1 : SP_2015_NA0010_120_170_20150527_00007.jpg

LM Start	7.87	Rating **	M	Issue No.	170
LM End	13.79	Issue Type +	Ma	Location *	WS
Category	Earthen Levee			GPS Latitude/Longitude	
				Start	End
Item	Vegetation			37.231603 °	°
				-120.812190 °	°
DWR ID	DWR_NA0010_02B_s_2015_170				
Action/Comments					
Control annual grass and weeds on the levee slopes and easements.

Looking northwest at typical view of waterward slope.

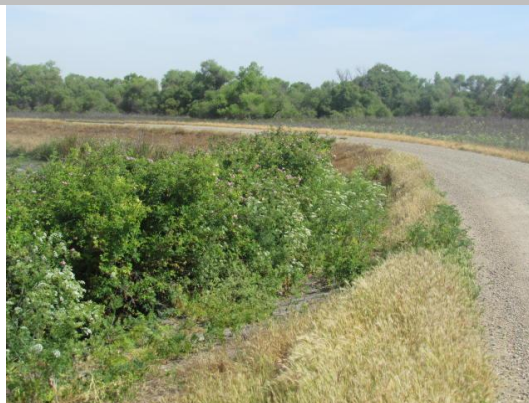
Photo 1 of 1 : SP_2015_NA0010_120_5_20150309_00005.jpg

LM Start	12.10	Rating **	A/W	Issue No.	5
LM End	12.10	Issue Type +	Ma	Location *	LS
Category	Earthen Levee			GPS Latitude/Longitude	
				Start	End
Item	Vegetation			37.193504 °	37.193504 °
				-120.763859 °	-120.763859 °
DWR ID	DWR_NA0010_02B_s_2012_5				
Action/Comments					
Remove the wild growth other than native grasses from the levee slopes.					
Inspector Comments: Remove wild roses on landside toe.

Looking north at wildroses on landward slope.

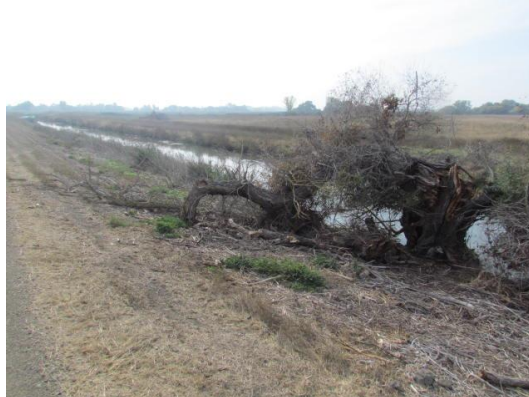
Photo 2 of 2 : SP_2015_NA0010_120_1_20150309_00002.jpg

LM Start	12.25	Rating **	M	Issue No.	1 (cont)	
LM End	12.25	Issue Type +	Ma	Location *	LS	
Category	Earthen Levee			GPS Latitude/Longitude		
				Start		End
Item	Encroachments			37.191500 °		37.191500 °
				-120.764521 °		-120.764521 °
DWR ID	DWR_NA0010_02B_f_2014_1					
Action/Comments						
Tree or limb						
Inspector Comments: Fallen tree limbs on landward slope.

Looking southwest at tree limb on waterward slope.

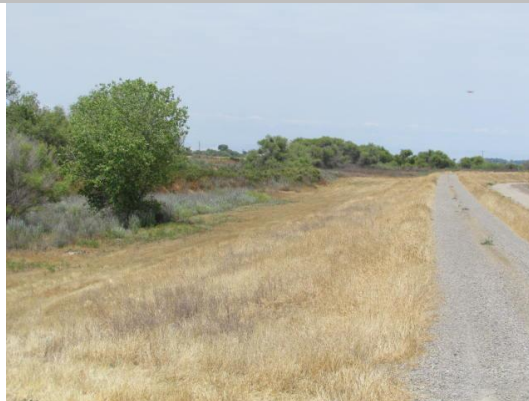
Photo 1 of 1 : SP_2015_NA0010_121_66_20150527_00023.jpg

LM Start	0.00	Rating **	M	Issue No.	66
LM End	2.10	Issue Type +	Ma	Location *	WS
Category	Earthen Levee			GPS Latitude/Longitude	
				Start	End
Item	Vegetation			37.111728 °	37.088908 °
				-120.587563 °	-120.566846 °
DWR ID	DWR_NA0010_03_s_2015_66				
Action/Comments					
Control annual grass and weeds on the levee slopes and easements.					
Inspector Comments: Control annual growth on waterward slope.

Looking at typical view of waterward slope.

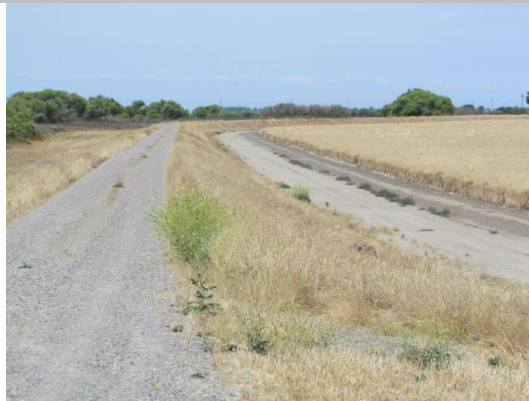
Photo 1 of 1 : SP_2015_NA0010_121_4_20150527_00024.jpg

LM Start	0.40	Rating **	M	Issue No.	4
LM End	2.09	Issue Type +	Ma	Location *	LS
Category	Earthen Levee			GPS Latitude/Longitude	
				Start	End
Item	Vegetation			37.106450 °	37.088965 °
				-120.586024 °	-120.566867 °
DWR ID	DWR_NA0010_03_f_2014_4				
Action/Comments					
Control annual grass and weeds on the levee slopes and easements. Inspector Comments: Control growth on landward slope.

Looking at typical view of landward slope.

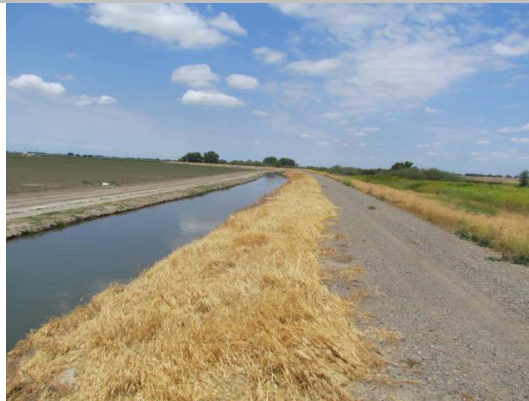
Photo 1 of 1 : SP_2015_NA0010_122_105_20150527_00051.jpg

LM Start	0.00	Rating **	M	Issue No.	105
LM End	1.19	Issue Type +	Ma	Location *	LS
Category	Earthen Levee			GPS Latitude/Longitude	
				Start	End
Item	Vegetation			37.112570 °	37.100055 °
				-120.589082 °	-120.580240 °
DWR ID	DWR_NA0010_04_s_2015_105				
Action/Comments					
Control annual grass and weeds on the levee slopes and easements.					
Inspector Comments: Control growth on landward slope.

Looking at typical view of landward slope.

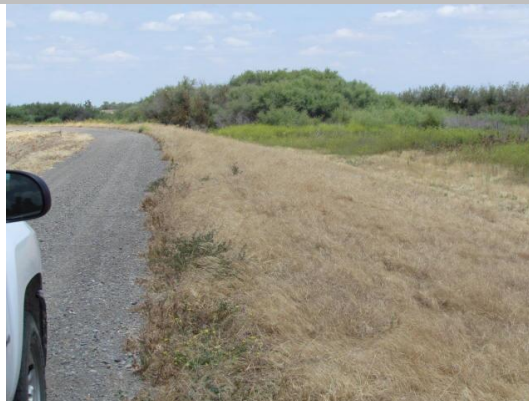
Photo 1 of 1 : SP_2015_NA0010_122_106_20150527_00052.jpg

LM Start	0.00	Rating **	M	Issue No.	106
LM End	1.41	Issue Type +	Ma	Location *	WS
Category	Earthen Levee			GPS Latitude/Longitude	
				Start	End
Item	Vegetation			37.112570 °	37.097534 °
				-120.589082 °	-120.578145 °
DWR ID	DWR_NA0010_04_s_2015_106				
Action/Comments					
Control annual grass and weeds on the levee slopes and easements. Inspector Comments: Control growth on waterward slope.

Looking at typical view of waterward slope.

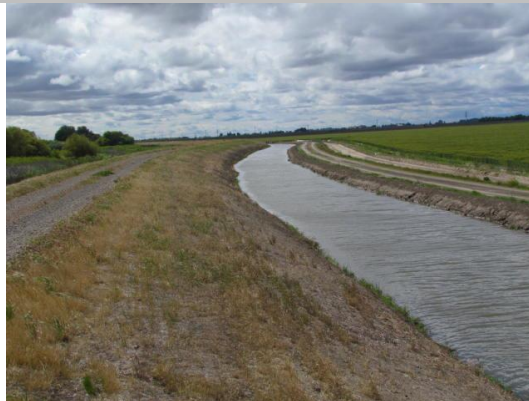
Photo 1 of 3 : SP_2015_NA0010_122_3_20150309_00001.jpg

LM Start	0.32	Rating **	M	Issue No.	3 (cont)
LM End	1.49	Issue Type +	En	Location *	LS

Looking north at irrigation ditch at landside toe.

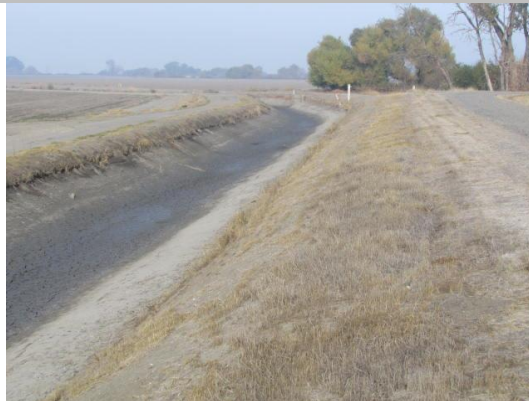
Photo 2 of 3 : SP_2015_NA0010_122_3_20150309_00002.jpg

Looking north at irrigation ditch at landward toe. (Fall 2013)

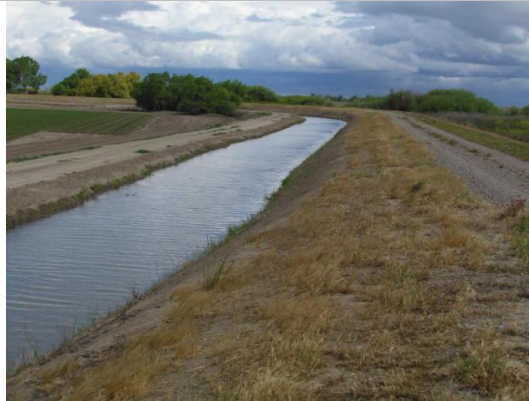
Photo 3 of 3 : SP_2015_NA0010_122_3_20150309_00003.jpg

Looking north at irrigation ditch at landside toe.

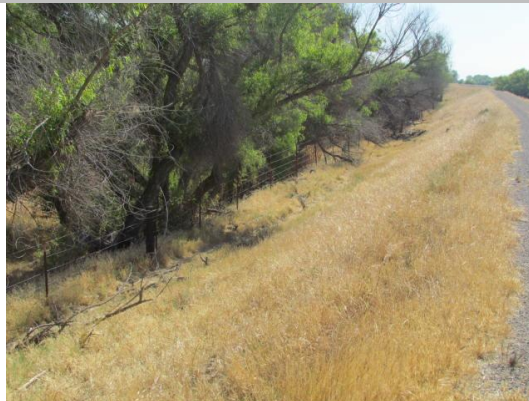
Photo 2 of 2 : SP_2015_NA0010_123_1308_20150527_00460.jpg

LM Start	2.82	Rating **	M	Issue No.	1308 (cont)
LM End	2.82	Issue Type +	Ma	Location *	LS
Category	Earthen Levee			GPS Latitude/Longitude	
				Start	End
Item	Encroachments			37.256783 °	37.256783 °
				-120.785438 °	-120.785438 °
DWR ID	DWR_NA0010_05_s _ 2015_1308				
Action/Comments					
Tree or limb					
Inspector Comments: Discard dead tree limbs at landward toe.

Looking south at several dead tree limbs on landward toe.

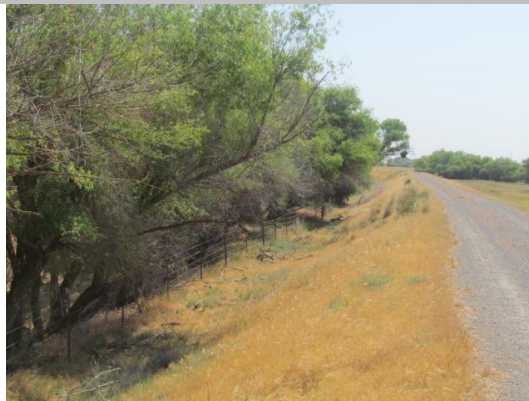
Photo 1 of 2 : SP_2015_NA0010_123_3_20150309_00002.jpg

LM Start	2.82	Rating **	A/W	Issue No.	3
LM End	2.87	Issue Type +	Ma	Location *	LS
Category	Earthen Levee			GPS Latitude/Longitude	
				Start	End
Item	Trim / Thin Trees			37.256803 °	37.256835 °
				-120.785407 °	-120.784528 °
DWR ID	DWR_NA0010_05_s _ 2012_3				
Action/Comments					
Thin trees to allow visibility of the ground and room to flood fight.

Looking south at trimmed trees on landward slope and toe.

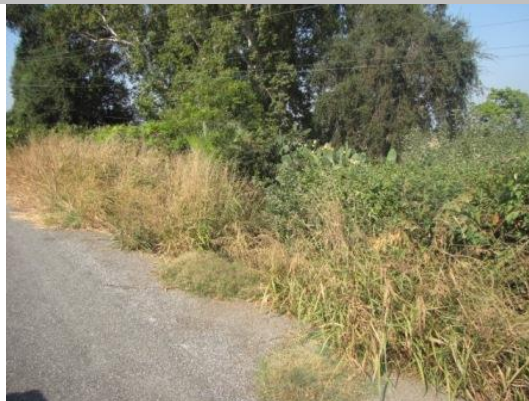
Photo 2 of 2 : SP_2015_NA0010_123_3_20150309_00003.jpg

LM Start	2.82	Rating **	A/W	Issue No.	3 (cont)
LM End	2.87	Issue Type +	Ma	Location *	LS

Looking south at dense trees on landside slope.

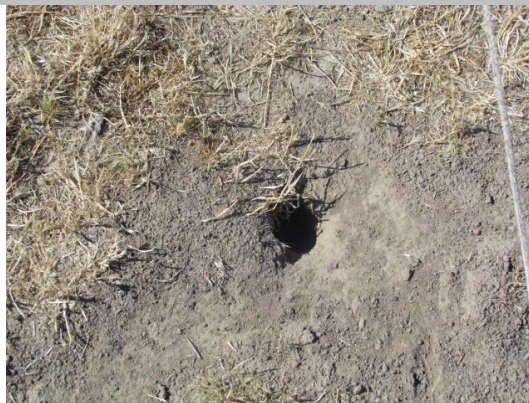
Photo 1 of 1 : SP_2015_NA0010_123_6_20150527_00461.jpg

LM Start	3.20	Rating **	M	Issue No.	6
LM End	3.20	Issue Type +	Ma	Location *	WS
Category	Earthen Levee			GPS Latitude/Longitude	
				Start	End
Item	Animal Control			37.256635 °	37.256635 °
				-120.778935 °	-120.778935 °
DWR ID	DWR_NA0010_05_s _ 2014_6				
Action/Comments					
Exterminate rodents and backfill and compact or grout burrows. Inspector Comments: No rodent visible but several rodent holes visible.

Looking at typical view of rodent holes on waterward slope.

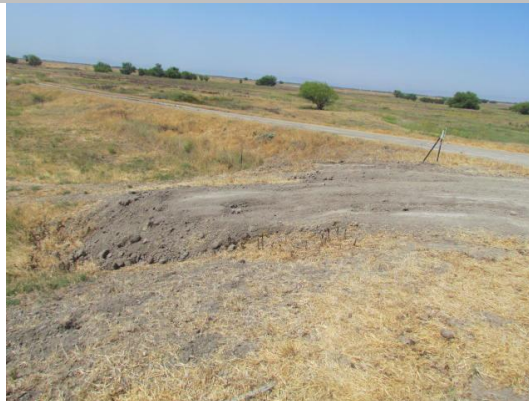
Photo 2 of 3 : SP_2015_NA0010_123_7_20150309_00005.jpg

LM Start	3.20	Rating **	M	Issue No.	7 (cont)	
LM End	3.20	Issue Type +	En	Location *	WS	
Category	Earthen Levee			GPS Latitude/Longitude		
				Start		End
Item	Encroachments			37.256554 °		37.256554 °
				-120.778847 °		-120.778847 °
DWR ID	DWR_NA0010_05_f_2012_7					
Action/Comments						
Ramp						
Inspector Comments: Unauthorized ramp on waterside slope.

Looking northwest at unauthorized ramp on waterward slope.

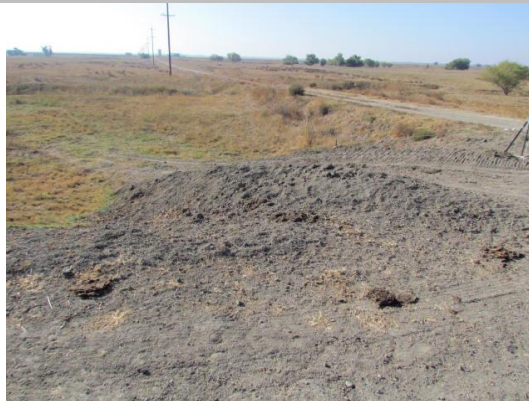
Photo 3 of 3 : SP_2015_NA0010_123_7_20150309_00006.jpg

Looking northwest at unauthorized ramp on waterside slope.

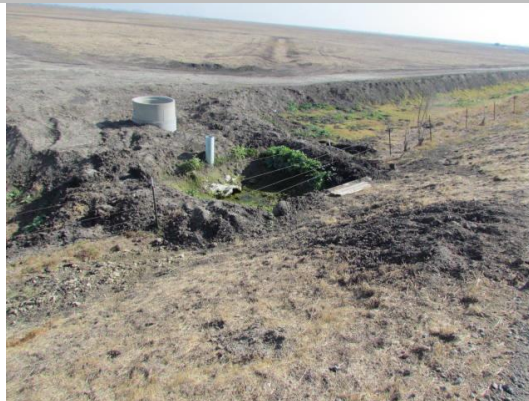
Photo 1 of 2 : SP_2015_NA0010_123_8_20150309_00007.jpg

LM Start	5.58	Rating **	A/W	Issue No.	8
LM End	5.58	Issue Type +	En	Location *	LS
Category	Earthen Levee			GPS Latitude/Longitude	
				Start	End
Item	Encroachments			37.238970 °	37.238970 °
				-120.739688 °	-120.739688 °
DWR ID	DWR_NA0010_05_s _ 2014_8				
Action/Comments					
Pipe Inspector Comments: Landowner installed 18" pvc pipe to 24" drain pipe. Eighteen inch pipe has a water meter installed. It appears that dike around drainage structure will prevent proper drainage.

Looking west at drain structure on landward toe.

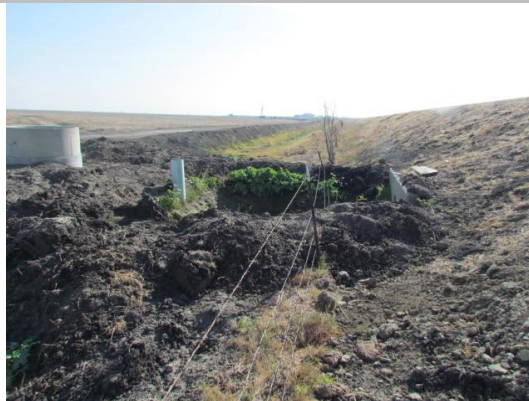
Photo 2 of 2 : SP_2015_NA0010_123_8_20150309_00008.jpg

LM Start	5.58	Rating **	A/W	Issue No.	8 (cont)
LM End	5.58	Issue Type +	En	Location *	LS

Looking south at drain structure on landward toe.

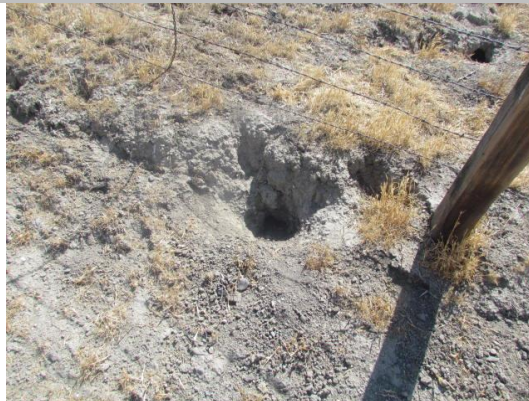
Photo 1 of 2 : SP_2015_NA0010_124_10_20150309_00011.jpg

LM Start	4.66	Rating **	M	Issue No.	10
LM End	4.66	Issue Type +	Ma	Location *	LS
Category	Earthen Levee			GPS Latitude/Longitude	
				Start	End
Item	Animal Control			37.243540 °	37.243540 °
				-120.760782 °	-120.760782 °
DWR ID	DWR_NA0010_06_s _ 2012_10				
Action/Comments					
No rodents visible, but rodent burrows visible; need to backfill and compact or grout burrows. Inspector Comments: Rodent holes next to fence post on landward slope.

Looking at rodent hole along fence line on landward slope.

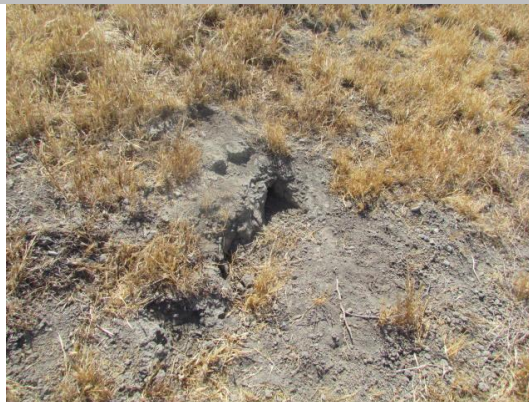
Photo 2 of 2 : SP_2015_NA0010_124_10_20150309_00012.jpg

Looking at typical rodent holes on landward slope.

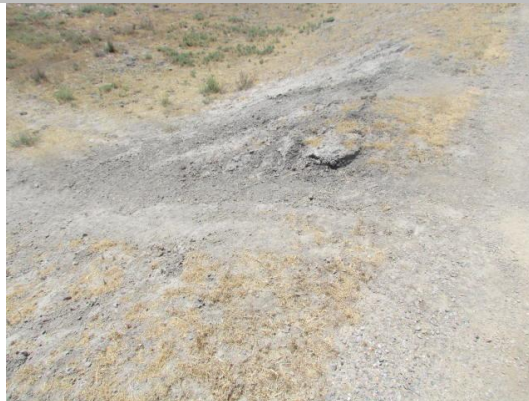
Photo 2 of 2 : SP_2015_NA0010_124_9_20150309_00010.jpg

LM Start	5.76	Rating **	A/W	Issue No.	9 (cont)
LM End	5.76	Issue Type +	Ma	Location *	LS
Category	Earthen Levee			GPS Latitude/Longitude	
				Start	End
Item	Slope Stability			37.238355 °	37.238355 °
				-120.742677 °	-120.742677 °
DWR ID	DWR_NA0010_06_s _ 2012_9				
Action/Comments					
Repair the levee slope damaged by vehicle traffic and prevent access where possible.					
Inspector Comments: Levee damage caused by motorcycle traffic.

Looking at slope damage caused by vehicle traffic on landward slope.

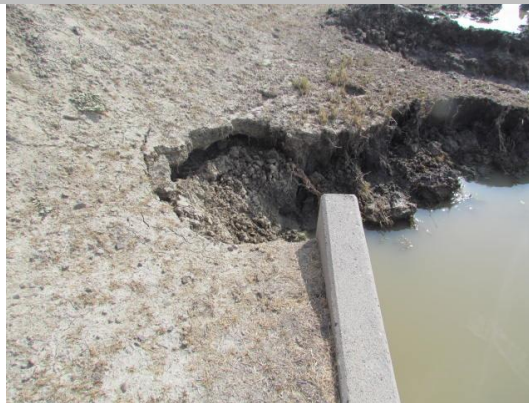
Photo 1 of 2 : SP_2015_NA0010_124_65_20150309_00016.jpg

LM Start	5.98	Rating **	U	Issue No.	65
LM End	5.98	Issue Type +	Ma	Location *	LS
Category	Interior Drainage & Piping Systems			GPS Latitude/Longitude	
				Start	End
Item	Erosion Areas			37.236372 °	37.236372 °
				-120.739706 °	-120.739706 °
DWR ID	DWR_NA0010_06_f _ 2014_65				
Action/Comments					
Inspector Comments: Erosion on right side of headwall at landward toe.

Looking northwest at erosion around headwall of drainage structure on landward toe.

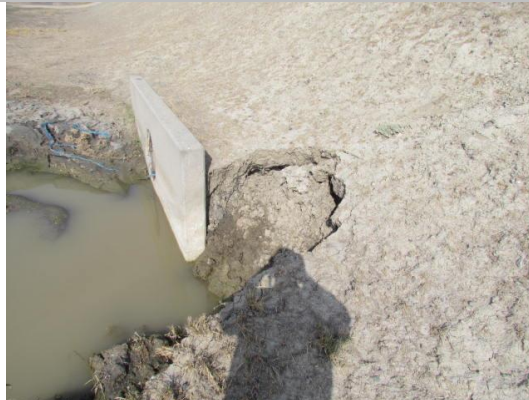
Photo 2 of 2 : SP_2015_NA0010_124_65_20150309_00017.jpg

Looking south erosion around headwall of drainage structure on landward toe.

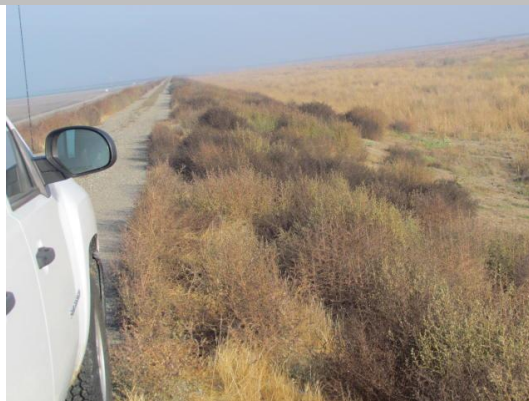
Photo 1 of 1 : SP_2015_NA0010_124_64_20150309_00015.jpg

LM Start	16.89	Rating **	A/W	Issue No.	64
LM End	18.79	Issue Type +	Ma	Location *	WS
Category	Earthen Levee			GPS Latitude/Longitude	
				Start	End
Item	Vegetation			37.144128 °	37.119569 °
				-120.602479 °	-120.587353 °
DWR ID	DWR_NA0010_06_f_2014_64				
Action/Comments					
Remove the wild growth other than native grasses from the levee slopes.					
Inspector Comments: Dense tumble weeds on waterward slope.

Looking northeast at dense tumble weeds on waterward slope.

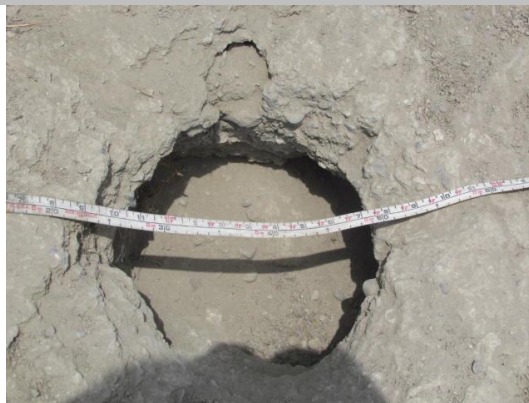
Photo 1 of 3 : SP_2015_NA0010_124_1211_20150528_00402.jpg

Looking at close-up view of large rodent hole on waterward slope.

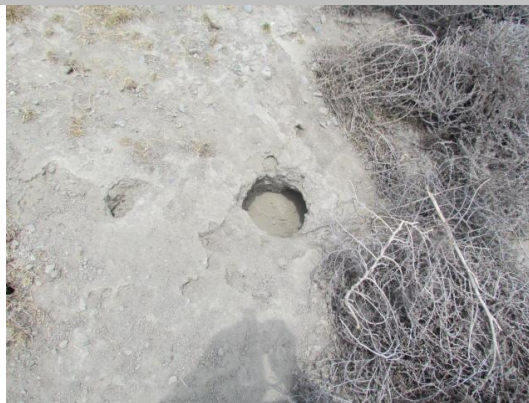
Photo 2 of 3 : SP_2015_NA0010_124_1211_20150528_00400.jpg

Looking at large rodent hole on waterward slope.

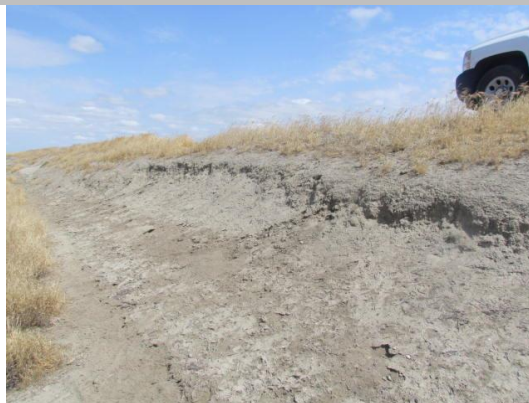
Photo 2 of 2 : SP_2015_NA0010_124_1209_20150528_00404.jpg

Looking northeast at livestock erosion on landward slope.

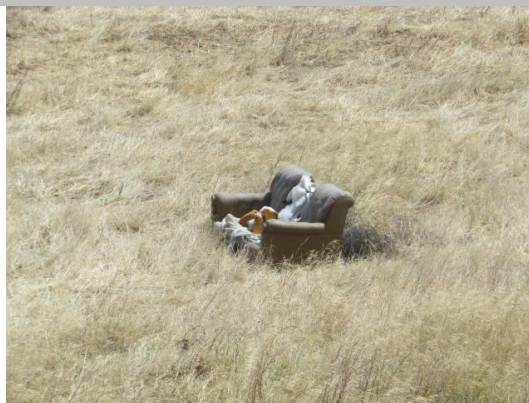
Photo 1 of 1 : SP_2015_NA0010_124_1210_20150528_00405.jpg

LM Start	20.83	Rating **	M	Issue No.	1210
LM End	20.83	Issue Type +	En	Location *	WS
Category	Earthen Levee			GPS Latitude/Longitude	
				Start	End
Item	Encroachments			37.112782 °	37.112782 °
				-120.563170 °	-120.563170 °
DWR ID	DWR_NA0010_06_s _ 2015_1210				
Action/Comments					
Garbage					
Inspector Comments: Garbage (sofa) dump on waterward berm about 100 plus feet away from waterward toe.

Looking east at garbage (soft) on waterward berm.

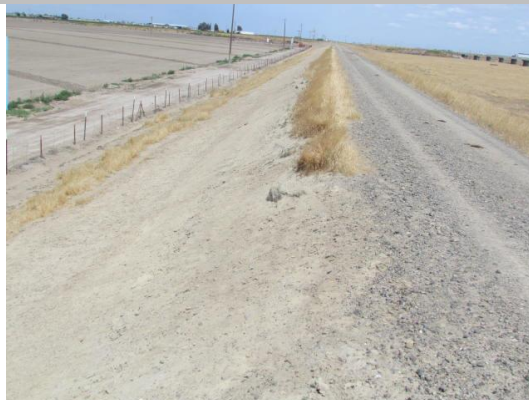
Photo 1 of 3 : SP_2015_NA0010_124_5_20150528_00406.jpg

LM Start	24.58	Rating **	M	Issue No.	5
LM End	24.93	Issue Type +	Ma	Location *	LS
Category	Earthen Levee			GPS Latitude/Longitude	
				Start	End
Item	Slope Stability			37.071198 °	°
				-120.519220 °	°
DWR ID	DWR_NA0010_06_s _ 2012_5				
Action/Comments					
Repair the levee slope damaged by foot traffic and prevent access where possible.					
Inspector Comments: Landside erosion caused by livestock.

Looking north at livestock erosion on landward slope. (Spring 2015)

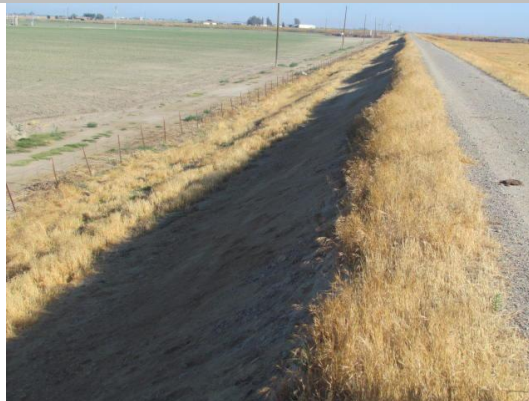
Photo 2 of 3 : SP_2015_NA0010_124_5_20150309_00007.jpg

LM Start	24.58	Rating **	M	Issue No.	5 (cont)	
LM End	24.93	Issue Type +	Ma	Location *	LS	
Category	Earthen Levee			GPS Latitude/Longitude		
				Start		End
Item	Slope Stability			37.071198 °		°
				-120.519220 °		°
DWR ID	DWR_NA0010_06_s _ 2012_5					
Action/Comments						
Repair the levee slope damaged by foot traffic and prevent access where possible.						
Inspector Comments: Landside erosion caused by livestock.

Looking north at livestock erosion on landward slope. (Spring 2014)

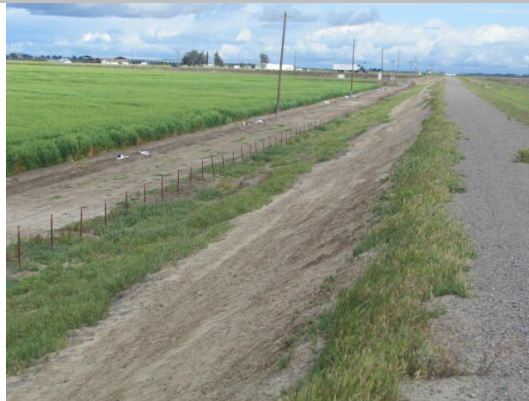
Photo 3 of 3 : SP_2015_NA0010_124_5_20150309_00008.jpg

Looking north at livestock erosion on landside slope. (Fall 2014)

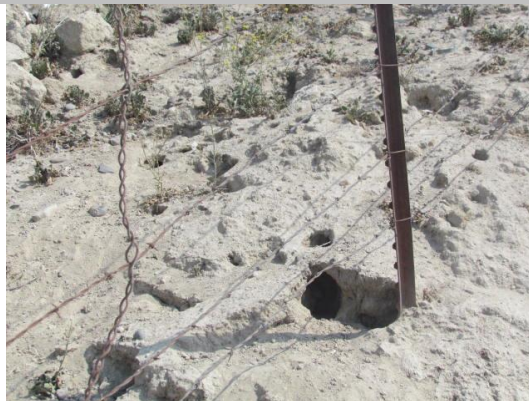
Photo 1 of 1 : SP_2015_NA0010_124_1208_20150528_00407.jpg

LM Start	26.13	Rating **	M	Issue No.	1208
LM End	26.13	Issue Type +	Ma	Location *	LS
Category	Earthen Levee			GPS Latitude/Longitude	
				Start	End
Item	Animal Control			37.054222 °	37.054222 °
				-120.500862 °	-120.500862 °
DWR ID	DWR_NA0010_06_s _ 2015_1208				
Action/Comments					
Exterminate rodents and backfill and compact or grout burrows. Inspector Comments: Noted several rodent holes next to and within rock revertment on landward slope.

Looking northeast at several rodent holes on landward slope.

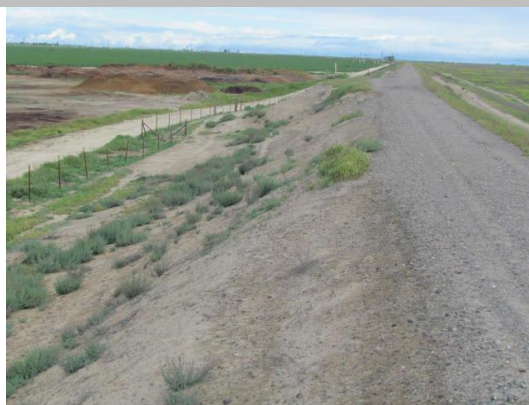
Photo 2 of 5 : SP_2015_NA0010_124_3_20150309_00003.jpg

Looking north at livestock erosion on landside shoulder and slope. (Fall 2014)

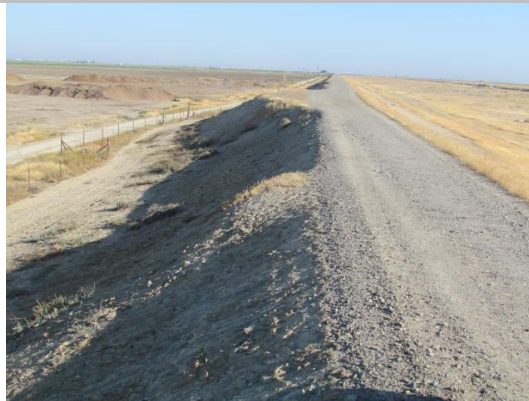
Photo 4 of 5 : SP_2015_NA0010_124_3_20150309_00005.jpg

LM Start	27.64	Rating **	M	Issue No.	3 (cont)	
LM End	27.97	Issue Type +	Ma	Location *	LS	
Category	Earthen Levee			GPS Latitude/Longitude		
				Start		End
Item	Slope Stability			37.036955 °		37.032887 °
				-120.484395 °		-120.481225 °
DWR ID	DWR_NA0010_06_s _ 2012_3					
Action/Comments						
Repair the levee slope damaged by foot traffic and prevent access where possible.						
Inspector Comments: Landside erosion caused by livestock. Erosion greater than 3" in depth on landward slope. Levee crown has narrowed within this reach.

Looking north at livestock erosion on landward slope. (Spring 2013)

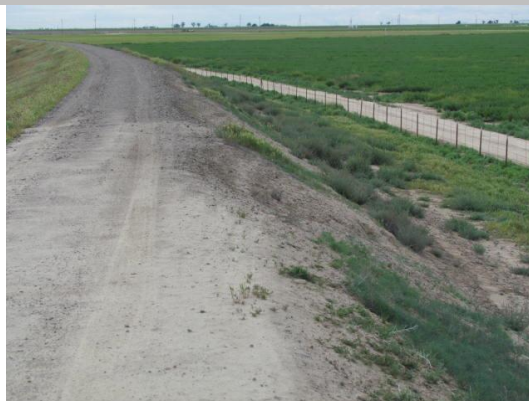
Photo 5 of 5 : SP_2015_NA0010_124_3_20150309_00006.jpg

Looking south at livestock erosion on landside shoulder and slope.

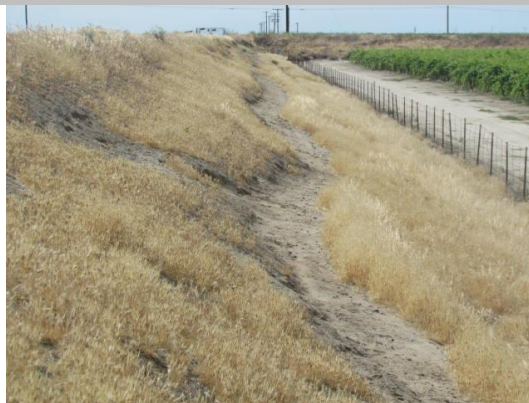
Photo 2 of 2 : SP_2015_NA0010_124_1207_20150528_00410.jpg

Looking south at livestock erosion on landward slope.

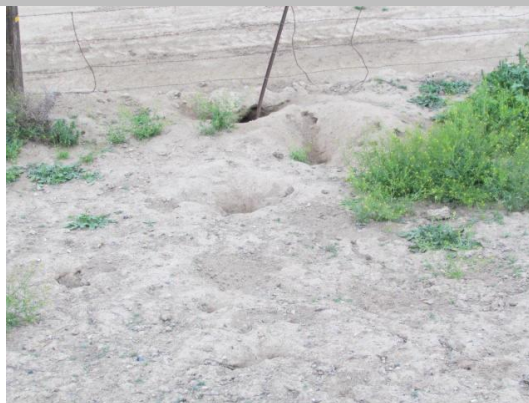
Photo 1 of 2 : SP_2015_NA0010_124_2_20150309_00001.jpg

LM Start	31.10	Rating **	M	Issue No.	2
LM End	31.10	Issue Type +	Ma	Location *	LS
Category	Earthen Levee			GPS Latitude/Longitude	
				Start	End
Item	Animal Control			37.017955 °	37.017955 °
				-120.435017 °	-120.435017 °
DWR ID	DWR_NA0010_06_s _ 2012_2				
Action/Comments					
Exterminate rodents and backfill and compact or grout burrows.

Looking west at rodent holes on landside slope and toe near fence line.

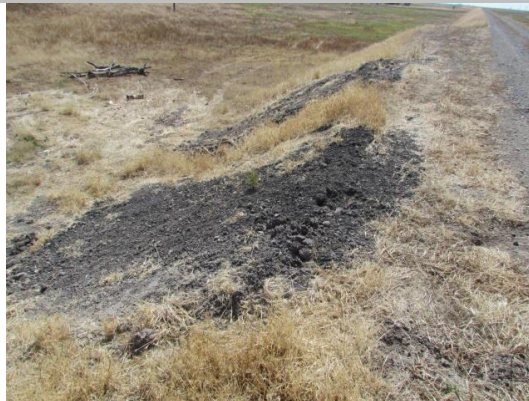
Photo 1 of 5 : SP_2015_NA0010_125_3_20150528_00012.jpg

LM Start	1.50	Rating **	A/W	Issue No.	3
LM End	1.50	Issue Type +	Ma	Location *	LS
Category	Earthen Levee			GPS Latitude/Longitude	
				Start	End
Item	Animal Control			37.263930 °	37.263930 °
				-120.750680 °	-120.750680 °
DWR ID	DWR_NA0010_07_s_2012_3				
Action/Comments					
Repair the levee slope damaged by livestock and prevent large animal access.					
Inspector Comments: Erosion on landward slope has been repaired by district. Landward toe erosion not repaired.

Looking east at repaired landward slope.

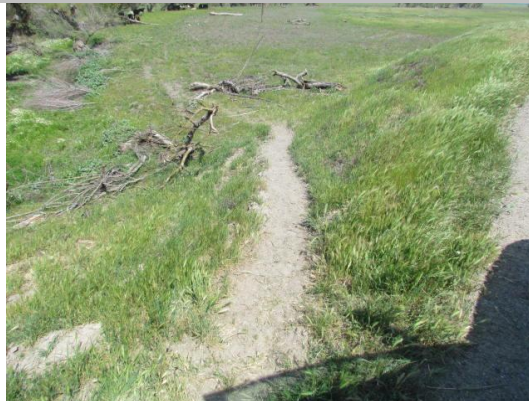
Photo 2 of 5 : SP_2015_NA0010_125_3_20150309_00003.jpg

Looking northeast at landside slope damaged by livestock.

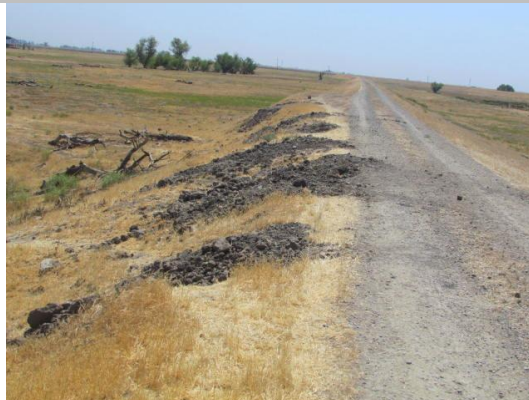
Photo 3 of 5 : SP_2015_NA0010_125_3_20150309_00004.jpg

Looking south at landward slope.

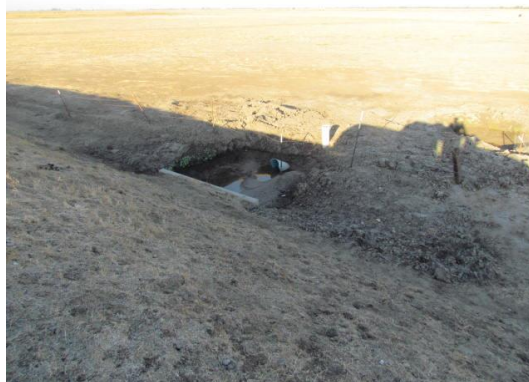
Photo 1 of 1 : SP_2015_NA0010_125_8_20150309_00007.jpg

LM Start	2.63	Rating **	A/W	Issue No.	8
LM End	2.63	Issue Type +	En	Location *	LS
Category	Earthen Levee			GPS Latitude/Longitude	
				Start	End
Item	Encroachments			37.254896 °	37.254896 °
				-120.734926 °	-120.734926 °
DWR ID	DWR_NA0010_07_s_2014_8				
Action/Comments					
Pipe					
Inspector Comments: Same landowner at LM 2.48 is connecting eighteen inch to drain pipe to montior water draining into channel. Landowner has corrected site according to Board standards.

Looking west at site corrected according to Board standards.

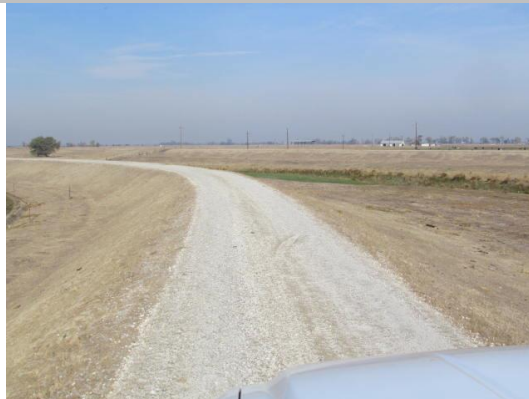
Photo 1 of 2 : SP_2015_NA0010_126_28_20150309_00005.jpg

LM Start	0.01	Rating **	A/W	Issue No.	28
LM End	2.22	Issue Type +	Ma	Location *	LS
Category	Earthen Levee			GPS Latitude/Longitude	
				Start	End
Item	Vegetation			37.253178 °	37.256802 °
				-120.768513 °	-120.740452 °
DWR ID	DWR_NA0010_08_s _ 2012_28				
Action/Comments					
Keep the crown roadway free of vegetation.

Looking west at levee crown in complies with standards.

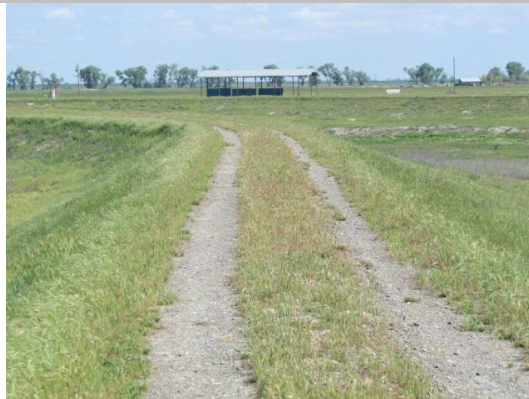
Photo 2 of 2 : SP_2015_NA0010_126_28_20150309_00006.jpg

Looking west at vegetation on levee crown.

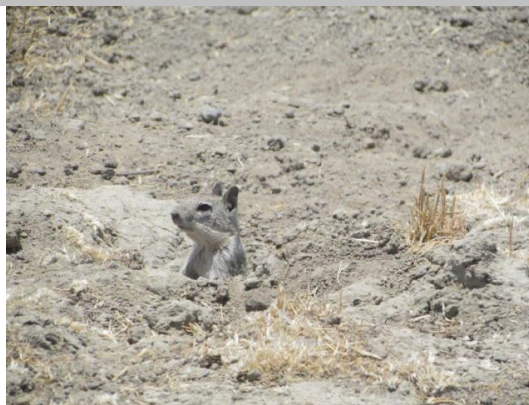
Photo 1 of 1 : SP_2015_NA0010_126_8_20150309_00004.jpg

Looking west at rodent holes on landward slope.

Action/Comments					
Exterminate rodents and backfill and compact or grout burrows.
