**Flood Control Project Maintenance
Levee Inspections****LMA District Cover Sheet****Spring 2015 Levee Inspection Results****Lower San Joaquin Levee District**

Spring 2015 Levee Inspection Results

Lower San Joaquin Levee District

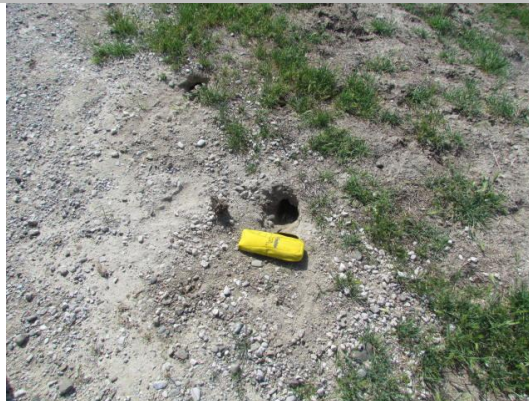
Photo 2 of 4 : SP_2015_NA0010_126_7_20150309_00001.jpg

LM Start	2.07	Rating **	M	Issue No.	7 (cont)
LM End	2.13	Issue Type +	Ma	Location *	LS
Category	Earthen Levee			GPS Latitude/Longitude	
				Start	End
Item	Animal Control			37.258063 °	37.257688 °
				-120.742460 °	-120.741573 °
DWR ID	DWR_NA0010_08_s_2012_7				
Action/Comments					
Exterminate rodents and backfill and compact or grout burrows. Inspector Comments: Several rodent holes were noted on landside slope near drainage pipe. Also noted rodent holes near gate.

Looking at typical rodent hole along the section.

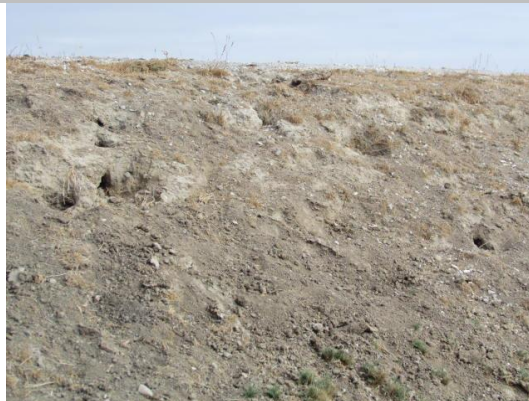
Photo 3 of 4 : SP_2015_NA0010_126_7_20150309_00002.jpg

Looking south at several rodent holes on landward slope.

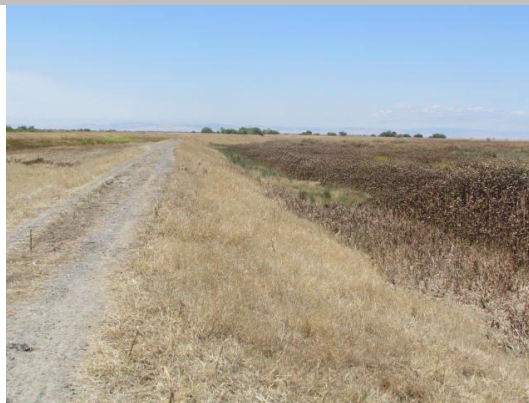
Photo 1 of 1 : SP_2015_NA0010_127_33_20150528_00010.jpg

LM Start	0.00	Rating **	A	Issue No.	33
LM End	0.87	Issue Type +	Ma	Location *	LS
Category	Earthen Levee			GPS Latitude/Longitude	
				Start	End
Item	Vegetation				° 37.220075 °
					° -120.698360 °
DWR ID	DWR_NA0010_09_s _ 2015_33				
Action/Comments					
Control annual grass and weeds on the levee slopes and easements.

Looking at typical view of landward slope.

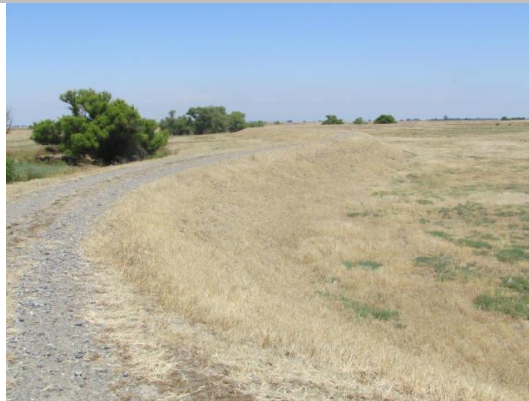
Photo 1 of 1 : SP_2015_NA0010_128_49_20150528_00009.jpg

LM Start	0.00	Rating **	M	Issue No.	49
LM End	0.78	Issue Type +	Ma	Location *	LS
Category	Earthen Levee			GPS Latitude/Longitude	
				Start	End
Item	Vegetation			37.217918 °	37.219343 °
				-120.711430 °	-120.698195 °
DWR ID	DWR_NA0010_10_s_2015_49				
Action/Comments					
Control annual grass and weeds on the levee slopes and easements.

Looking at typical view of landward slope.

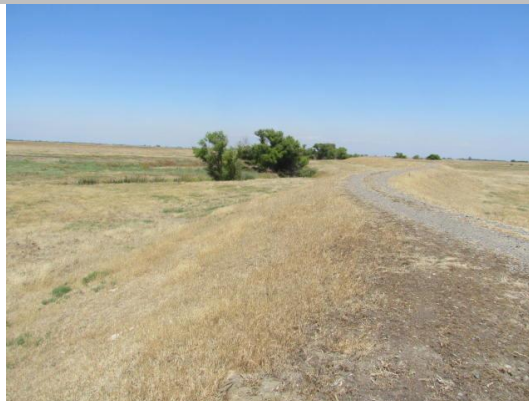
Photo 1 of 1 : SP_2015_NA0010_128_50_20150528_00008.jpg

LM Start	0.00	Rating **	M	Issue No.	50
LM End	0.78	Issue Type +	Ma	Location *	WS
Category	Earthen Levee			GPS Latitude/Longitude	
				Start	End
Item	Vegetation			37.217918 °	37.219343 °
				-120.711430 °	-120.698195 °
DWR ID	DWR_NA0010_10_s_2015_50				
Action/Comments					
Control annual grass and weeds on the levee slopes and easements.

Looking at typical view of waterward slope.

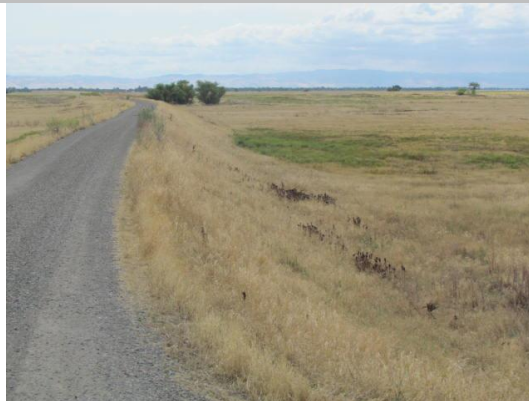
Photo 1 of 1 : SP_2015_NA0010_129_136_20150528_00037.jpg

LM Start	0.00	Rating **	M	Issue No.	136
LM End	3.31	Issue Type +	Ma	Location *	LS
Category	Earthen Levee			GPS Latitude/Longitude	
				Start	End
Item	Vegetation			37.202777 °	37.202333 °
				-120.755150 °	-120.695280 °
DWR ID	DWR_NA0010_11_s_2015_136				
Action/Comments					
Control annual grass and weeds on the levee slopes and easements. Inspector Comments: Control growth on landward slope.

Looking at typical view of landward slope.

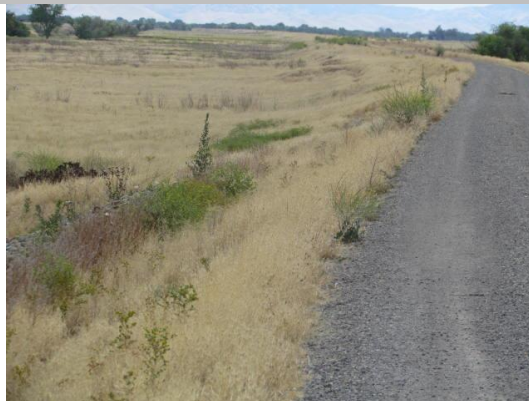
Photo 1 of 1 : SP_2015_NA0010_129_137_20150528_00038.jpg

LM Start	0.00	Rating **	M	Issue No.	137
LM End	3.31	Issue Type +	Ma	Location *	WS
Category	Earthen Levee			GPS Latitude/Longitude	
				Start	End
Item	Vegetation			37.202778 °	37.202333 °
				-120.755150 °	-120.695280 °
DWR ID	DWR_NA0010_11_s_2015_137				
Action/Comments					
Control annual grass and weeds on the levee slopes and easements. Inspector Comments: Control growth on waterward slope.

Looking at typical view of waterward slope.

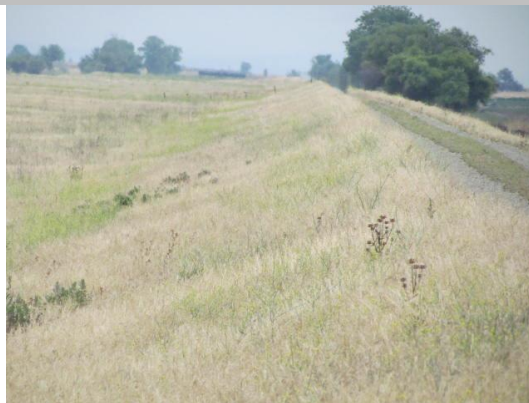
Photo 1 of 1 : SP_2015_NA0010_130_149_20150528_00077.jpg

LM Start	0.00	Rating **	M	Issue No.	149
LM End	3.33	Issue Type +	Ma	Location *	WS
Category	Earthen Levee			GPS Latitude/Longitude	
				Start	End
Item	Vegetation			37.200935 °	°
				-120.755205 °	°
DWR ID	DWR_NA0010_12_s_2015_149				
Action/Comments					
Control annual grass and weeds on the levee slopes and easements. Inspector Comments: Control growth on waterward slope.

Looking at typical view of growth on waterward slope.

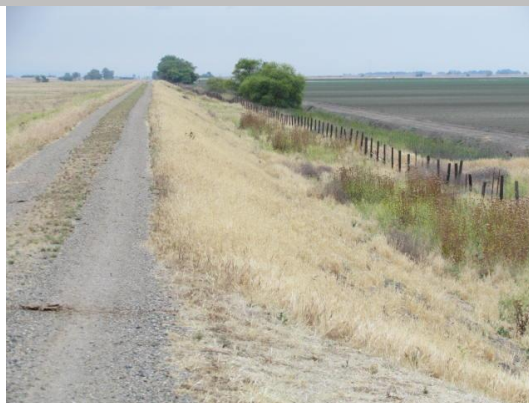
Photo 1 of 1 : SP_2015_NA0010_130_148_20150528_00078.jpg

LM Start	0.00	Rating **	M	Issue No.	148
LM End	3.33	Issue Type +	Ma	Location *	LS
Category	Earthen Levee			GPS Latitude/Longitude	
				Start	End
Item	Vegetation			37.200934 °	37.200959 °
				-120.755205 °	-120.694810 °
DWR ID	DWR_NA0010_12_s_2015_148				
Action/Comments					
Control annual grass and weeds on the levee slopes and easements. Inspector Comments: Control growth on landward slope.

Looking at typical view of growth on landward slope.

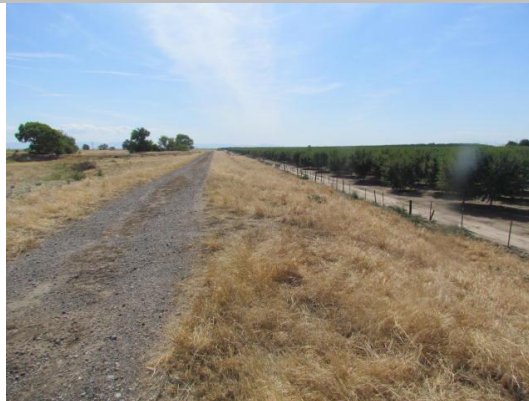
Photo 1 of 1 : SP_2015_NA0010_131_65_20150528_00026.jpg

LM Start	0.00	Rating **	M	Issue No.	65
LM End	1.26	Issue Type +	Ma	Location *	LS
Category	Earthen Levee			GPS Latitude/Longitude	
				Start	End
Item	Vegetation				° 37.046297 °
					° -120.428123 °
DWR ID	DWR_NA0010_13_s_2015_65				
Action/Comments					
Control annual grass and weeds on the levee slopes and easements. Inspector Comments: Control growth on landward slope.

Looking at typical view of growth on landward slope.

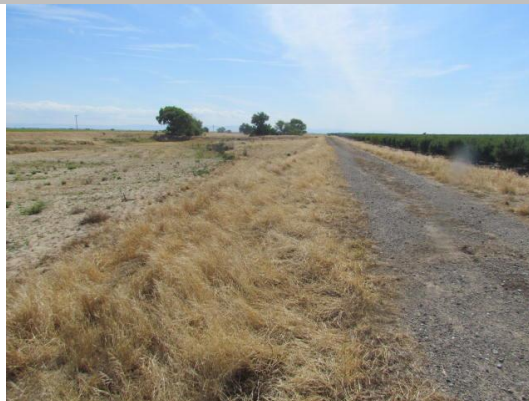
Photo 1 of 1 : SP_2015_NA0010_131_66_20150528_00027.jpg

LM Start	0.00	Rating **	M	Issue No.	66
LM End	1.26	Issue Type +	Ma	Location *	WS
Category	Earthen Levee			GPS Latitude/Longitude	
				Start	End
Item	Vegetation				° 37.046297 °
					° -120.428123 °
DWR ID	DWR_NA0010_13_s_2015_66				
Action/Comments					
Control annual grass and weeds on the levee slopes and easements. Inspector Comments: Control growth on waterward slope.

Looking at typical view of growth on waterward slope.

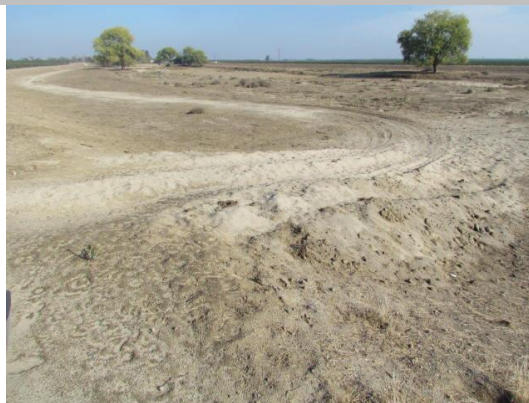
Photo 1 of 3 : SP_2015_NA0010_131_5_20150309_00001.jpg

Looking east at unauthorized ramp on waterward slope. (Fall 2014)

LM Start	0.91	Rating **	M	Issue No.	5 (cont)	
LM End	0.91	Issue Type +	En	Location *	WS	
Category	Earthen Levee			GPS Latitude/Longitude		
				Start		End
Item	Encroachments			37.044855 °		37.044855 °
				-120.434106 °		-120.434106 °
DWR ID	DWR_NA0010_13_s_2014_5					
Action/Comments						
Ramp						
Inspector Comments: Unauthorized ramp on waterward slope.

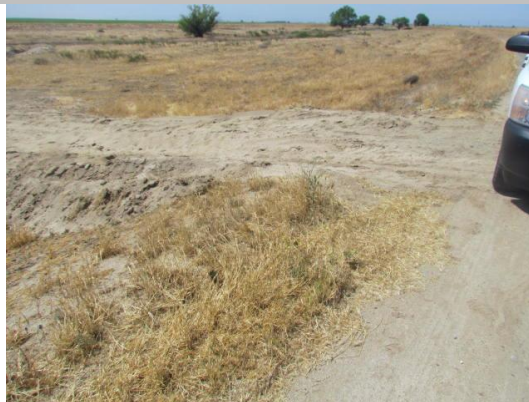
Photo 2 of 3 : SP_2015_NA0010_131_5_20150309_00002.jpg

Looking west at unauthorized ramp on waterward slope.

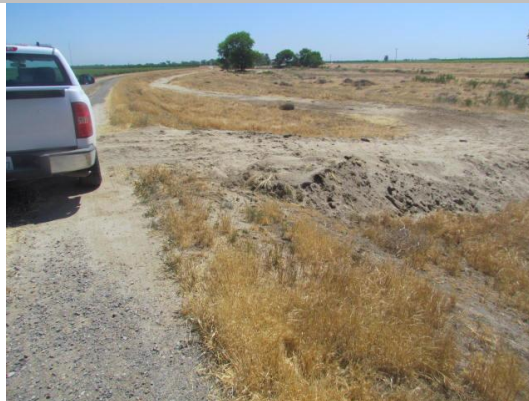
Photo 3 of 3 : SP_2015_NA0010_131_5_20150309_00003.jpg

Looking east at unauthorized ramp on waterward slope.

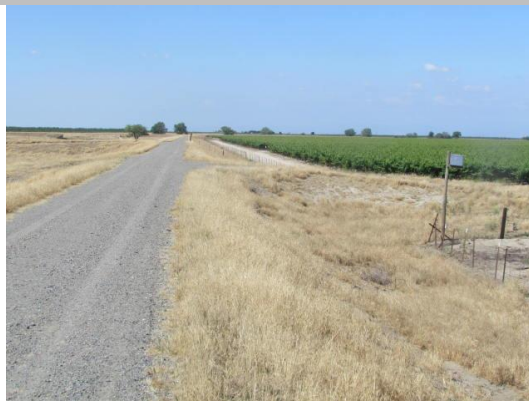
Photo 1 of 1 : SP_2015_NA0010_132_77_20150528_00030.jpg

LM Start	0.00	Rating **	M	Issue No.	77
LM End	1.26	Issue Type +	Ma	Location *	LS
Category	Earthen Levee			GPS Latitude/Longitude	
				Start	End
Item	Vegetation			37.032377 °	37.045398 °
				-120.441273 °	-120.427757 °
DWR ID	DWR_NA0010_14_s_2015_77				
Action/Comments					
Remove the wild growth other than native grasses from the levee slopes.					
Inspector Comments: Control growth on landward slope.

Looking at typical view of growth on landward slope.

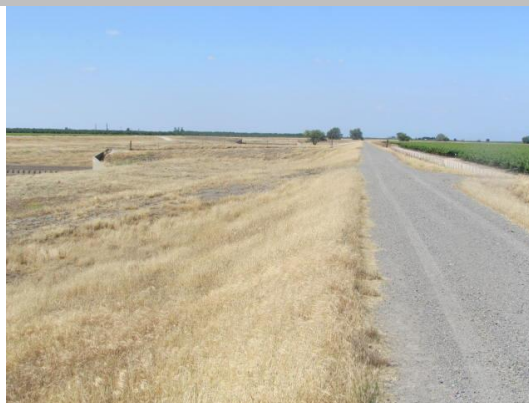
Photo 1 of 1 : SP_2015_NA0010_132_78_20150528_00031.jpg

LM Start	0.00	Rating **	M	Issue No.	78
LM End	1.26	Issue Type +	Ma	Location *	WS
Category	Earthen Levee			GPS Latitude/Longitude	
				Start	End
Item	Vegetation			37.032377 °	37.045398 °
				-120.441273 °	-120.427757 °
DWR ID	DWR_NA0010_14_s_2015_78				
Action/Comments					
Control annual grass and weeds on the levee slopes and easements. Inspector Comments: Control growth on waterward slope.

Looking at typical view of growth on waterward slope.

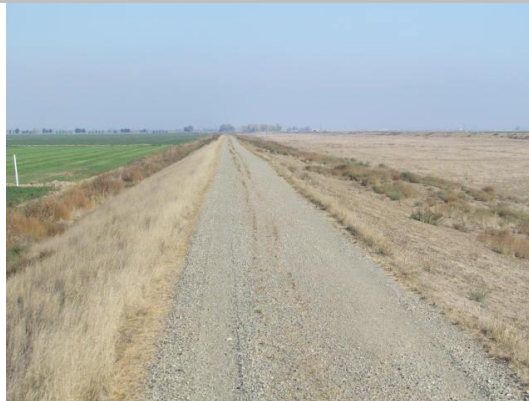
Photo 1 of 2 : SP_2015_NA0010_133_11_20150309_00001.jpg

LM Start	0.01	Rating **	A/W	Issue No.	11
LM End	1.99	Issue Type +	Ma	Location *	CR
Category	Earthen Levee			GPS Latitude/Longitude	
				Start	End
Item	Crown Surface / Depressions / Rutting			36.996547 °	36.996587 °
				-120.410220 °	-120.374503 °
DWR ID	DWR_NA0010_15_s_2012_11				
Action/Comments					
Add appropriate material and re-grade the levee to bring the crown above the design elevation.					
Inspector Comments: Control vegetation on levee crown.

Looking east at typical view of levee in compliance with standards.

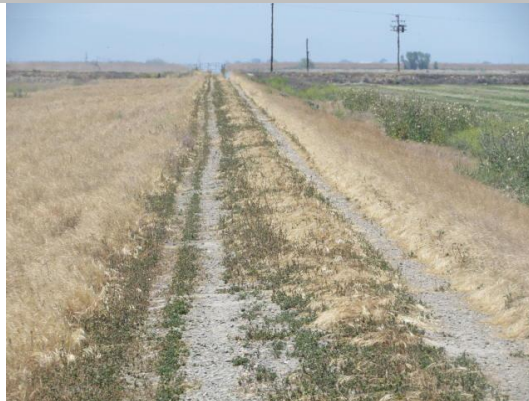
Photo 2 of 2 : SP_2015_NA0010_133_11_20150309_00002.jpg

Looking east at vegetation on levee crown.

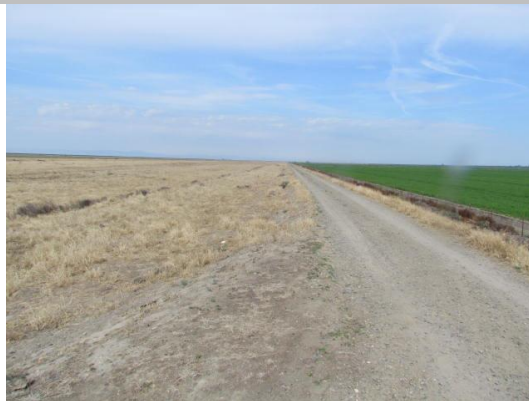
Photo 1 of 1 : SP_2015_NA0010_133_75_20150528_00009.jpg

LM Start	0.03	Rating **	M	Issue No.	75
LM End	2.02	Issue Type +	Ma	Location *	WS
Category	Earthen Levee			GPS Latitude/Longitude	
				Start	End
Item	Vegetation			36.996551 °	36.996560 °
				-120.409814 °	-120.383500 °
DWR ID	DWR_NA0010_15_s_2015_75				
Action/Comments					
Control annual grass and weeds on the levee slopes and easements.					
Inspector Comments: Control growth on waterward slope.

Looking at typical view of growth on waterward slope.

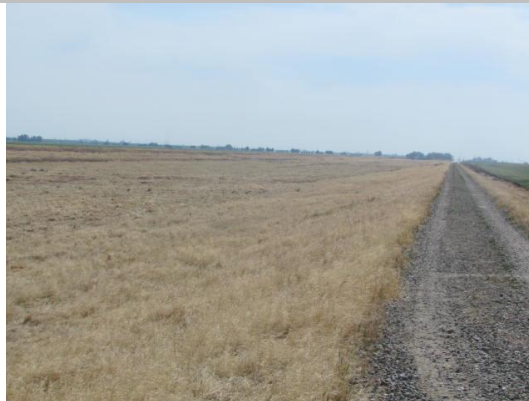
Photo 1 of 1 : SP_2015_NA0010_134_91_20150528_00022.jpg

LM Start	0.00	Rating **	M	Issue No.	91
LM End	1.96	Issue Type +	Ma	Location *	WS
Category	Earthen Levee			GPS Latitude/Longitude	
				Start	End
Item	Vegetation			36.995349 °	36.995456 °
				-120.408896 °	-120.383420 °
DWR ID	DWR_NA0010_16_s _ 2015_91				
Action/Comments					
Control annual grass and weeds on the levee slopes and easements. Inspector Comments: Control growth on waterward slope.

Looking at typical view of growth on waterward slope.

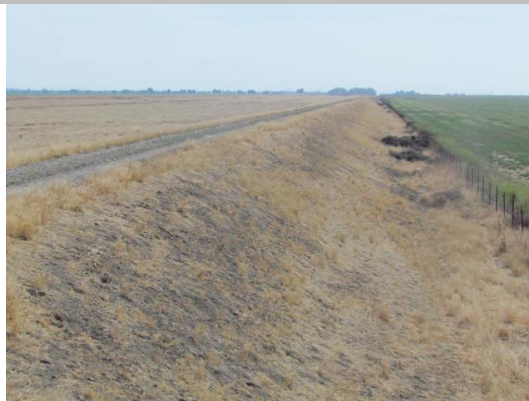
Photo 1 of 1 : SP_2015_NA0010_134_90_20150528_00023.jpg

LM Start	0.00	Rating **	M	Issue No.	90
LM End	1.97	Issue Type +	Ma	Location *	LS
Category	Earthen Levee			GPS Latitude/Longitude	
				Start	End
Item	Vegetation			36.995349 °	36.995457 °
				-120.408896 °	-120.383420 °
DWR ID	DWR_NA0010_16_s _ 2015_90				
Action/Comments					
Control annual grass and weeds on the levee slopes and easements. Inspector Comments: Control growth on landward slope.

Looking at typical view of growth on landward slope.

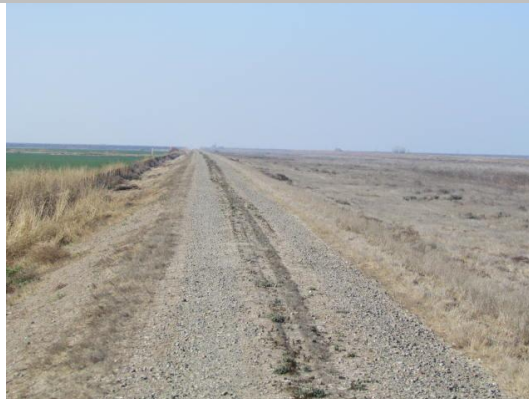
Photo 1 of 1 : SP_2015_NA0010_134_14_20150309_00003.jpg

LM Start	0.01	Rating **	A/W	Issue No.	14
LM End	1.96	Issue Type +	Ma	Location *	CR
Category	Earthen Levee			GPS Latitude/Longitude	
				Start	End
Item	Crown Surface / Depressions / Rutting			36.995388 °	36.995507 °
				-120.408738 °	-120.373592 °
DWR ID	DWR_NA0010_16_s _ 2012_14				
Action/Comments					
Add appropriate material and re-grade the levee to bring the crown above the design elevation.					
Inspector Comments: Control vegetation on levee crown.

Looking west at the properly maintained levee crown.

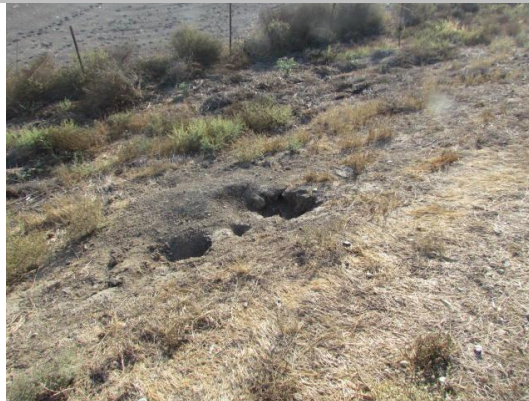
Photo 2 of 2 : SP_2015_NA0010_134_2_20150309_00002.jpg

LM Start	1.77	Rating **	M	Issue No.	2 (cont)	
LM End	1.77	Issue Type +	Ma	Location *	LS	
Category	Earthen Levee			GPS Latitude/Longitude		
				Start		End
Item	Animal Control			36.995487 °		36.995487 °
				-120.377054 °		-120.377054 °
DWR ID	DWR_NA0010_16_f_2014_2					
Action/Comments						
No rodents visible, but rodent burrows visible; need to backfill and compact or grout burrows.						
Inspector Comments: Large rodent holes on landward slope.

Looking southwest at several rodent holes on landward slope.

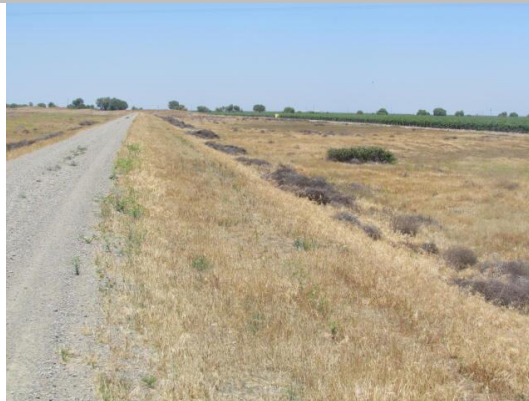
Photo 1 of 1 : SP_2015_NA0010_135_11_20150528_00112.jpg

LM Start	0.00	Rating **	M	Issue No.	11
LM End	16.09	Issue Type +	Ma	Location *	LS
Category	Earthen Levee			GPS Latitude/Longitude	
				Start	End
Item	Vegetation				o
					o
DWR ID	DWR_NA0010_17_f_2014_11				
Action/Comments					
Control annual grass and weeds on the levee slopes and easements. Inspector Comments: Control growth on landward slope.

Looking at typical view of growth on landward slope.

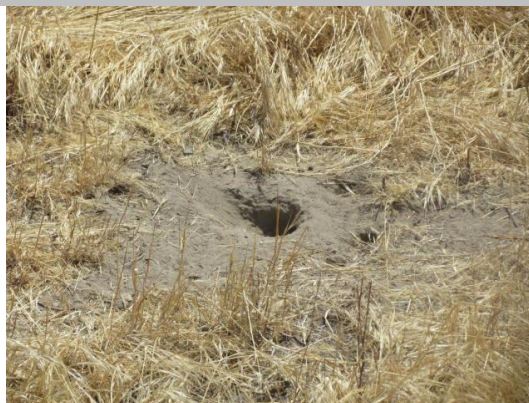
Photo 1 of 1 : SP_2015_NA0010_135_4_20150528_00115.jpg

LM Start	6.51	Rating **	M	Issue No.	4
LM End	6.60	Issue Type +	Ma	Location *	LS
Category	Earthen Levee			GPS Latitude/Longitude	
				Start	End
Item	Animal Control			36.898124 °	36.896943 °
				-120.326714 °	-120.326133 °
DWR ID	DWR_NA0010_17_s_2012_4				
Action/Comments					
Exterminate rodents and backfill and compact or grout burrows. Inspector Comments: Notice several rodent holes within this reach.

Looking at typical view of rodent holes on landward slope.

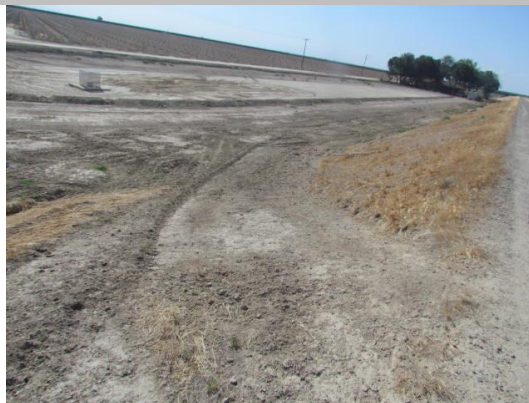
Photo 1 of 3 : SP_2015_NA0010_137_367_20150528_00045.jpg

LM Start	1.65	Rating **	M	Issue No.	367
LM End	1.65	Issue Type +	En	Location *	LS
Category	Earthen Levee			GPS Latitude/Longitude	
				Start	End
Item	Encroachments			36.953398 °	36.953398 °
				-120.351982 °	-120.351982 °
DWR ID	DWR_NA0010_18_s _ 2015_367				
Action/Comments					
Ramp Inspector Comments: Unauthorized ramp on landward and waterward slope.

Looking northwest at unauthorized ramp on landward slope.

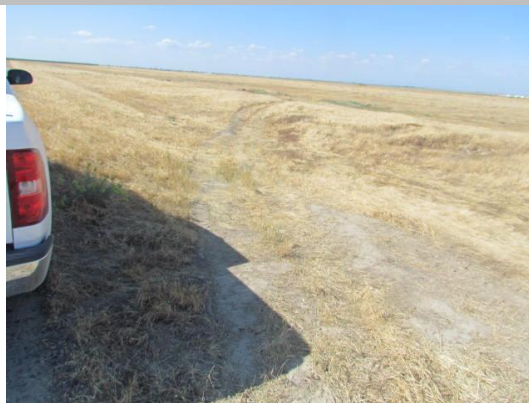
Photo 2 of 3 : SP_2015_NA0010_137_367_20150528_00046.jpg

Looking northeast on at unauthorized ramp on waterward slope.

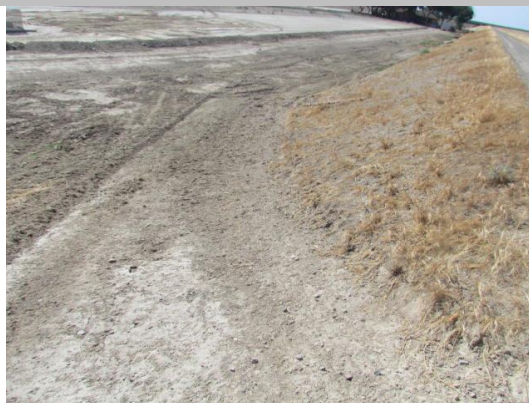
Photo 3 of 3 : SP_2015_NA0010_137_367_20150528_00047.jpg

Looking northeast at close-up view of ramp on landward slope.

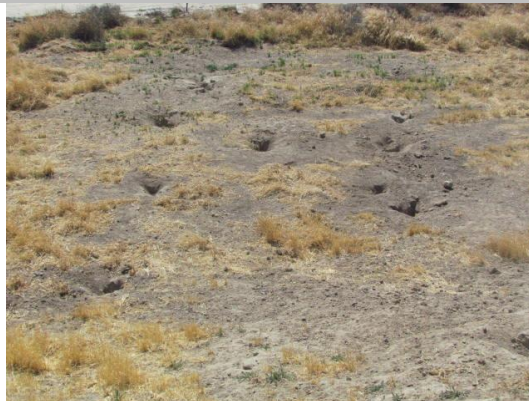
Photo 1 of 1 : SP_2015_NA0010_137_1_20150528_00048.jpg

LM Start	5.89	Rating **	M	Issue No.	1
LM End	5.89	Issue Type +	Ma	Location *	LS
Category	Earthen Levee			GPS Latitude/Longitude	
				Start	End
Item	Animal Control			36.895175 °	36.895175 °
				-120.327632 °	-120.327632 °
DWR ID	DWR_NA0010_18_s_2015_1				
Action/Comments					
No rodents visible, but rodent burrows visible; need to backfill and compact or grout burrows. Inspector Comments: Several large rodent holes noted on landward slope and berm within this section.

Looking at several rodent holes on landward slope.

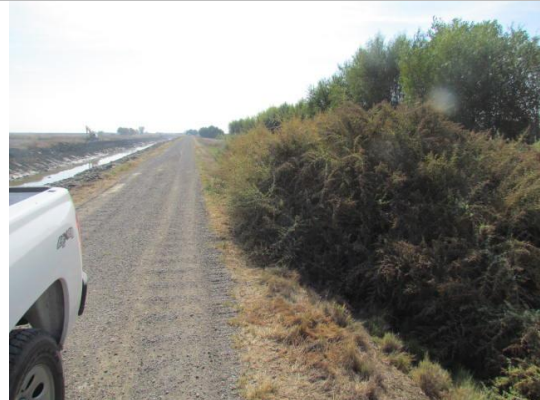
Photo 1 of 1 : SP_2015_NA0010_138_21_20150309_00011.jpg

Action/Comments					
Remove the wild growth other than native grasses from the levee slopes. Inspector Comments: Dense brush on landward slope.

Looking south at dense brushes on landward slope.

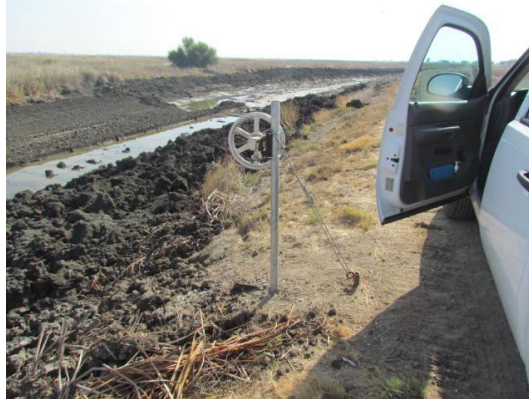
Photo 1 of 1 : SP_2015_NA0010_138_23_20150309_00015.jpg

LM Start	0.87	Rating **	M	Issue No.	23
LM End	0.87	Issue Type +	En	Location *	WS
Category	Earthen Levee			GPS Latitude/Longitude	
				Start	End
Item	Encroachments			37.217802 °	37.217802 °
				-120.697416 °	-120.697416 °
DWR ID	DWR_NA0010_22A_f_2014_23				
Action/Comments					
Sign Inspector Comments: Pulley on waterward shouder without board permit.

Looking south at pulley on waterward shoulder.

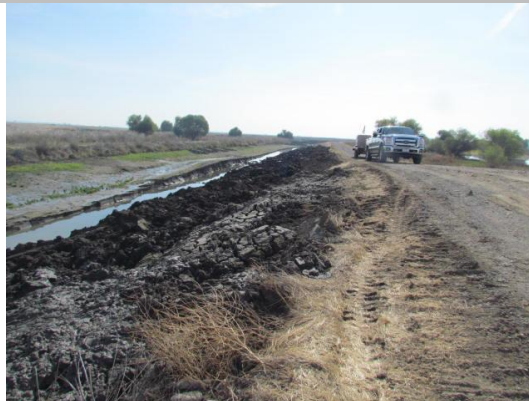
Photo 1 of 3 : SP_2015_NA0010_138_22_20150309_00012.jpg

LM Start	0.96	Rating **	A/W	Issue No.	22
LM End	0.96	Issue Type +	Ma	Location *	WS
Category	Earthen Levee			GPS Latitude/Longitude	
				Start	End
Item	Slope Stability			37.219137 °	37.219137 °
				-120.697857 °	-120.697857 °
DWR ID	DWR_NA0010_22A_f_2014_22				
Action/Comments					
Repair slope instability.					
Inspector Comments: Irrigation district excavated waterward slope.

Looking south at excavated waterward slope.

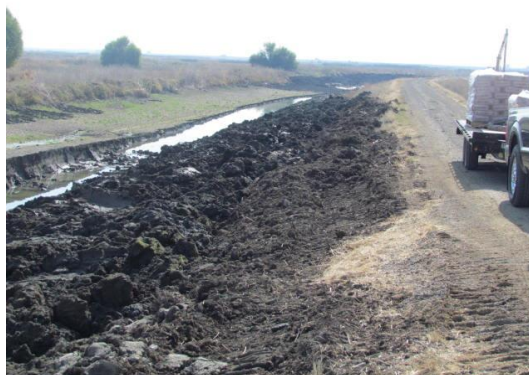
Photo 2 of 3 : SP_2015_NA0010_138_22_20150309_00013.jpg

Looking southeast at excavated waterward slope.

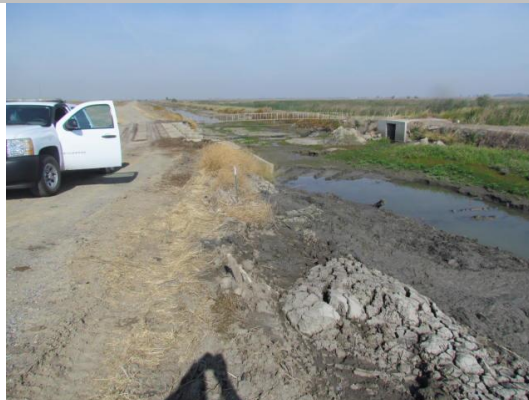
Photo 3 of 3 : SP_2015_NA0010_138_22_20150309_00014.jpg

Looking north at excavated waterward slope.

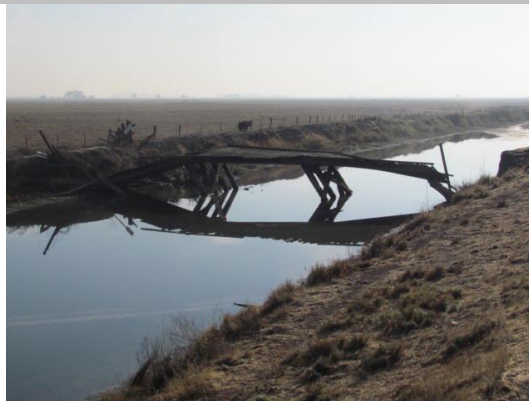
Photo 1 of 5 : SP_2015_NA0010_138_3_20150309_00001.jpg

LM Start	4.69	Rating **	A	Issue No.	3
LM End	4.69	Issue Type +	En	Location *	WS
Category	Rivers, Channels & Designated Floodways			GPS Latitude/Longitude	
				Start	End
Item	Encroachments			37.264250 °	37.264250 °
				-120.731280 °	-120.731280 °
DWR ID	DWR_NA0010_22A_f_2014_3				
Action/Comments					
Inspector Comments: Old wooden dilapidated bridge in channel needs to be removed.

Looking east at bridge in canal. (Fall 2014)

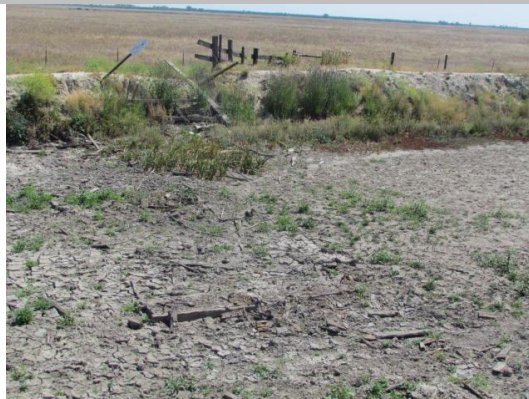
Photo 2 of 5 : SP_2015_NA0010_138_3_20150528_00051.jpg

Looking northeast at old site of dilapidated bridge. (Spring 2015)

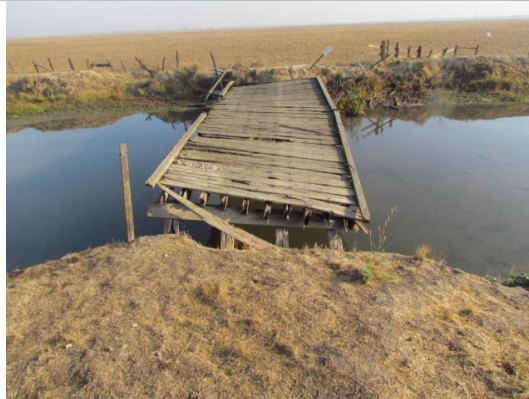
Photo 3 of 5 : SP_2015_NA0010_138_3_20150309_00002.jpg

Looking east at old bridge in canal. (Fall 2014)

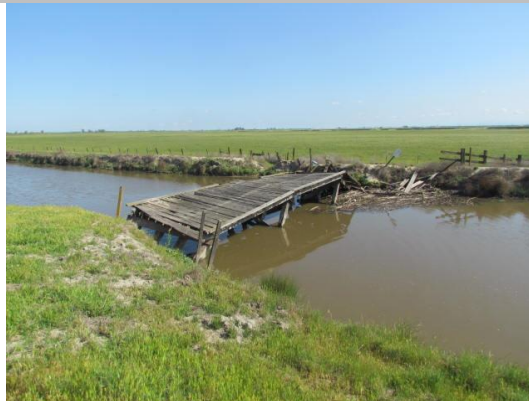
Photo 4 of 5 : SP_2015_NA0010_138_3_20150309_00003.jpg

Looking northeast at dilapidated bridge across canal.

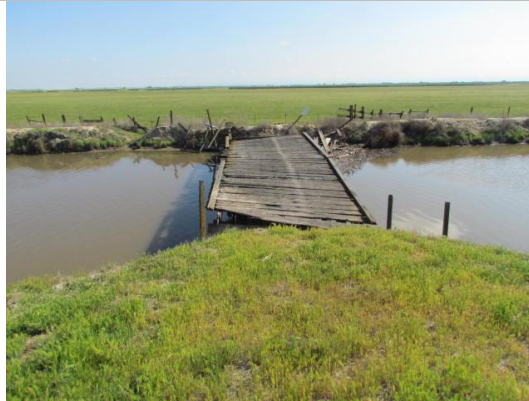
Photo 5 of 5 : SP_2015_NA0010_138_3_20150309_00004.jpg

Looking east at dilapidated bridge across canal.

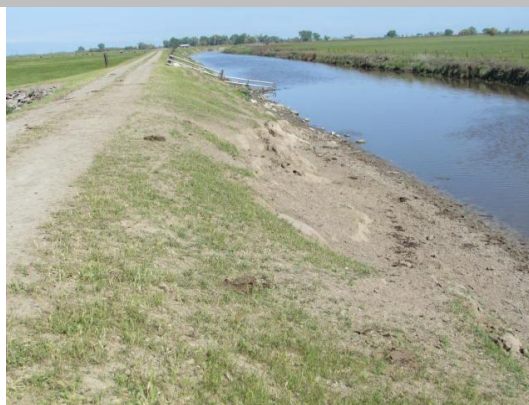
Photo 2 of 2 : SP_2015_NA0010_138_5_20150309_00007.jpg

LM Start	4.79	Rating **	A/W	Issue No.	5
LM End	4.86	Issue Type +	Ma	Location *	WS
Category	Earthen Levee			GPS Latitude/Longitude	
				Start	End
Item	Animal Control			37.265180 °	37.265743 °
				-120.732745 °	-120.733602 °
DWR ID	DWR_NA0010_22A_s_2012_5				
Action/Comments					
Repair the levee slope damaged by livestock and prevent large animal access.					
Inspector Comments: Erosion sites repaired by LMA on waterward toe.

Looking north at waterside erosion from livestock. (Fall 2014)

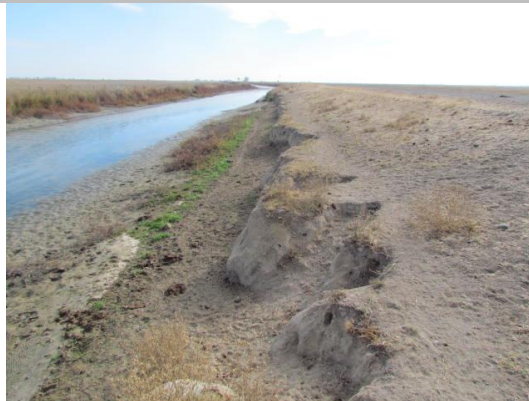
Photo 1 of 2 : SP_2015_NA0010_138_6_20150309_00008.jpg

LM Start	5.14	Rating **	M	Issue No.	6
LM End	5.20	Issue Type +	Ma	Location *	WS
Category	Earthen Levee			GPS Latitude/Longitude	
				Start	End
Item	Animal Control			37.268492 °	37.269133 °
				-120.737493 °	-120.738208 °
DWR ID	DWR_NA0010_22A_s_2012_6				
Action/Comments					
Repair the levee slope damaged by livestock and prevent large animal access.					
Inspector Comments: Erosion caused by livestock on waterside toe.

Looking south at livestock erosion on waterward toe.

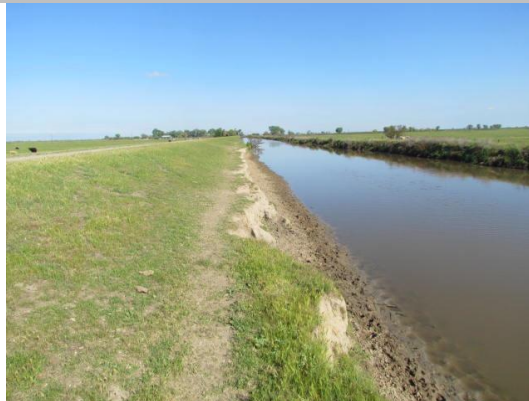
Photo 2 of 2 : SP_2015_NA0010_138_6_20150309_00009.jpg

Looking north at livestock erosion along waterside slope and toe.

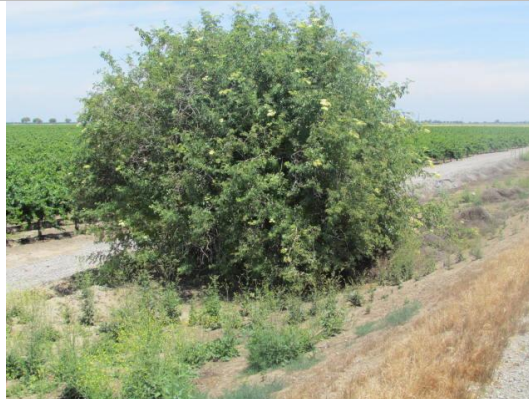
Photo 1 of 1 : SP_2015_NA0010_139_6_20150528_00114.jpg

LM Start	1.21	Rating **	M	Issue No.	6
LM End	1.21	Issue Type +	Ma	Location *	LS
Category	Earthen Levee			GPS Latitude/Longitude	
				Start	End
Item	Vegetation			36.772973 °	36.772973 °
				-120.264768 °	-120.264768 °
DWR ID	DWR_NA0010_23_s_2013_6				
Action/Comments					
Elderberries are blocking visibility and flood fight capability. Inspector Comments: Control growth of elderberry on landward toe.

Looking at elderberry on landward toe.

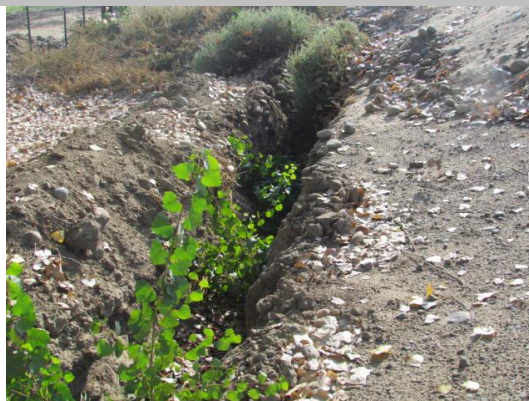
Photo 2 of 3 : SP_2015_NA0010_139_29_20150309_00015.jpg

LM Start	1.53	Rating **	M	Issue No.	29	
LM End	1.53	Issue Type +	Ma	Location *	LS	
Category	Earthen Levee			GPS Latitude/Longitude		
				Start	End	
Item	Slope Stability			36.772041 °	36.772041 °	
				-120.259549 °	-120.259549 °	
DWR ID	DWR_NA0010_23_f_2014_29					
Action/Comments						
Repair slope instability.						
Inspector Comments: Trench at landward toe. Trench is ten to twelve inches wide and twenty feet long.

Looking south at trench at landward toe.

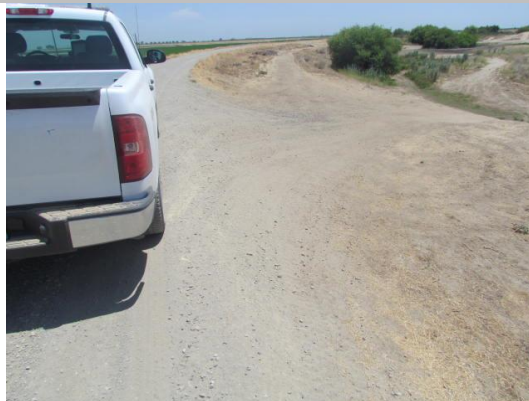
Photo 1 of 1 : SP_2015_NA0010_139_16_20150309_00012.jpg

LM Start	2.12	Rating **	M	Issue No.	16
LM End	2.42	Issue Type +	Ma	Location *	WS
Category	Earthen Levee			GPS Latitude/Longitude	
				Start	End
Item	Slope Stability			36.775507 °	36.774423 °
				-120.251672 °	-120.246993 °
DWR ID	DWR_NA0010_23_s_2013_16				
Action/Comments					
Repair the levee slope damaged by vehicle traffic and prevent access where possible.					
Inspector Comments: Several damaged sites within this reach. Damage caused by vehicle traffic.

Looking south at waterward slope damaged by vehicle traffic

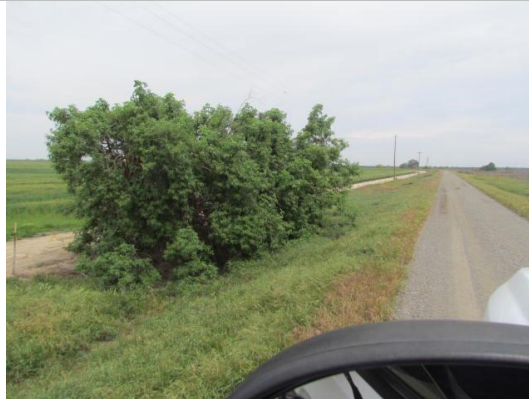
Photo 2 of 2 : SP_2015_NA0010_139_15_20150309_00011.jpg

LM Start	2.85	Rating **	M	Issue No.	15 (cont)
LM End	2.85	Issue Type +	Ma	Location *	LS
Category	Earthen Levee			GPS Latitude/Longitude	
				Start	End
Item	Vegetation			36.771537 °	36.771537 °
				-120.240917 °	-120.240917 °
DWR ID	DWR_NA0010_23_s_2012_15				
Action/Comments					
Elderberries are blocking visibility and flood fight capability. Inspector Comments: Control growth of elderberry bush on landward toe.

Looking south at elderberry on landside toe and berm. (Fall 2014)

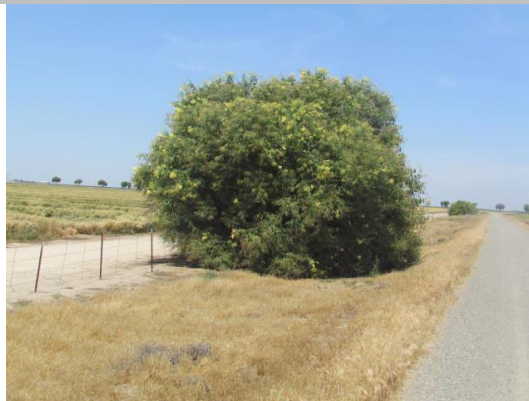
Photo 1 of 3 : SP_2015_NA0010_139_3_20150528_00117.jpg

LM Start	3.30	Rating **	M	Issue No.	3
LM End	3.30	Issue Type +	Ma	Location *	LS
Category	Earthen Levee			GPS Latitude/Longitude	
				Start	End
Item	Vegetation			36.774403 °	36.774403 °
				-120.234705 °	-120.234705 °
DWR ID	DWR_NA0010_23_s_2012_3				
Action/Comments					
Elderberries are blocking visibility and flood fight capability. Inspector Comments: Control growth of elderberry on landward toe.

Looking south at elderberry on landward toe and berm. (Spring 2015)

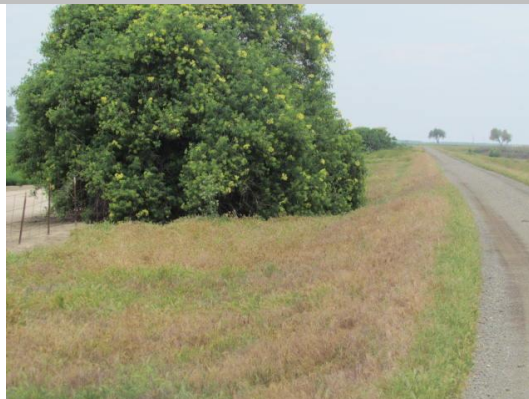
Photo 2 of 3 : SP_2015_NA0010_139_3_20150309_00002.jpg

Looking south at elderberry on landside toe and berm. (Fall 2014)

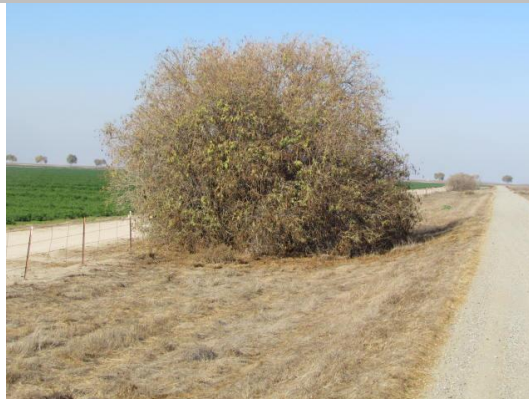
Photo 3 of 3 : SP_2015_NA0010_139_3_20150309_00001.jpg

LM Start	3.30	Rating **	M	Issue No.	3 (cont)	
LM End	3.30	Issue Type +	Ma	Location *	LS	
Category	Earthen Levee			GPS Latitude/Longitude		
				Start	End	
Item	Vegetation			36.774403 °	36.774403 °	
				-120.234705 °	-120.234705 °	
DWR ID	DWR_NA0010_23_s_2012_3					
Action/Comments						
Elderberries are blocking visibility and flood fight capability. Inspector Comments: Control growth of elderberry on landward toe.

Looking south at elderberry bush on landward toe. (Spring 2013)

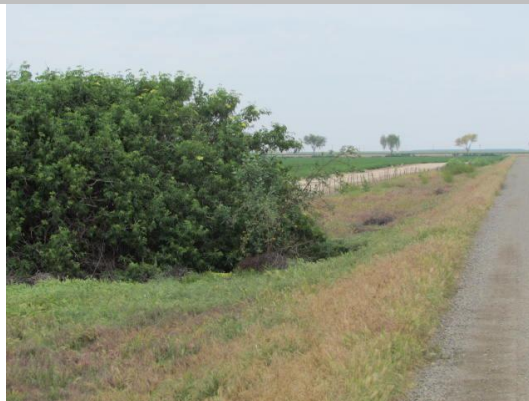
Photo 1 of 1 : SP_2015_NA0010_139_9_20150309_00004.jpg

LM Start	3.45	Rating **	M	Issue No.	9
LM End	3.45	Issue Type +	Ma	Location *	LS
Category	Earthen Levee			GPS Latitude/Longitude	
				Start	End
Item	Vegetation			36.776537 °	36.776537 °
				-120.234573 °	-120.234573 °
DWR ID	DWR_NA0010_23_s_2012_9				
Action/Comments					
Elderberries are blocking visibility and flood fight capability. Inspector Comments: Control growth of elderberry on landward toe and berm.

Looking south at elderberry on landside toe and berm.

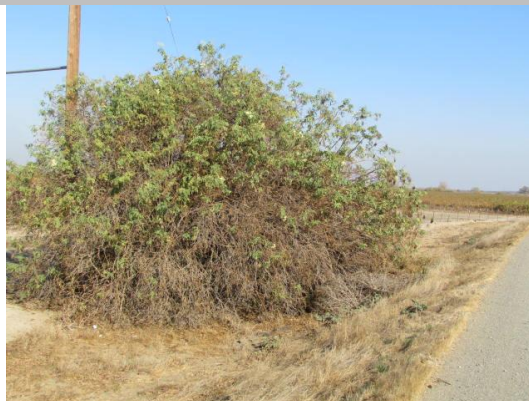
Photo 1 of 2 : SP_2015_NA0010_139_10_20150309_00005.jpg

LM Start	4.13	Rating **	M	Issue No.	10
LM End	4.13	Issue Type +	Ma	Location *	LS
Category	Earthen Levee			GPS Latitude/Longitude	
				Start	End
Item	Vegetation			36.784212 °	36.784212 °
				-120.228815 °	-120.228815 °
DWR ID	DWR_NA0010_23_s_2012_10				
Action/Comments					
Elderberries are blocking visibility and flood fight capability. Inspector Comments: Control growth of elderberry on landward toe.

Looking south at elderberry bush on landward toe. (Fall 2013)

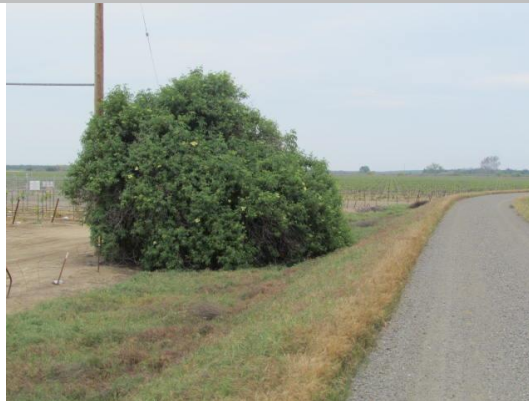
Photo 2 of 2 : SP_2015_NA0010_139_10_20150309_00006.jpg

LM Start	4.13	Rating **	M	Issue No.	10 (cont)
LM End	4.13	Issue Type +	Ma	Location *	LS
Category	Earthen Levee			GPS Latitude/Longitude	
				Start	End
Item	Vegetation			36.784212 °	36.784212 °
				-120.228815 °	-120.228815 °
DWR ID	DWR_NA0010_23_s_2012_10				
Action/Comments					
Elderberries are blocking visibility and flood fight capability. Inspector Comments: Control growth of elderberry on landward toe.

Looking south at elderberry on landside toe and berm.

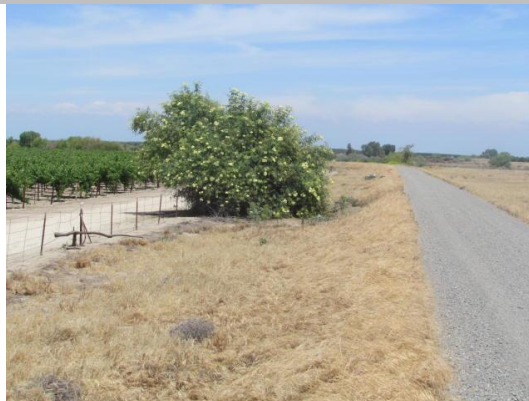
Photo 1 of 2 : SP_2015_NA0010_139_11_20150528_00118.jpg

LM Start	4.45	Rating **	M	Issue No.	11
LM End	4.45	Issue Type +	Ma	Location *	LS
Category	Earthen Levee			GPS Latitude/Longitude	
				Start	End
Item	Vegetation			36.784523 °	36.784523 °
				-120.223292 °	-120.223292 °
DWR ID	DWR_NA0010_23_s_2012_11				
Action/Comments					
Elderberries are blocking visibility and flood fight capability. Inspector Comments: Control growth of elderberry on landward toe and berm.

Looking south at elderberry on landward toe and berm. (Spring 2015)

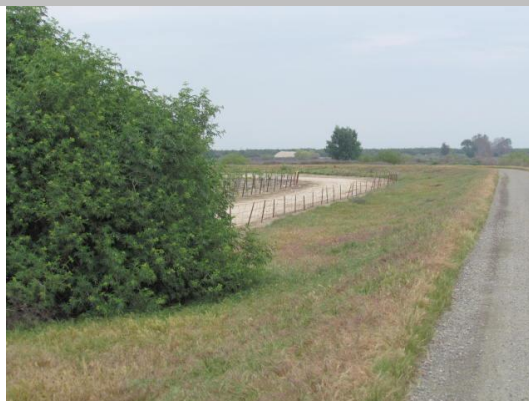
Photo 2 of 2 : SP_2015_NA0010_139_11_20150309_00007.jpg

LM Start	4.45	Rating **	M	Issue No.	11 (cont)
LM End	4.45	Issue Type +	Ma	Location *	LS

Looking south at elderberry on landside toe and berm.

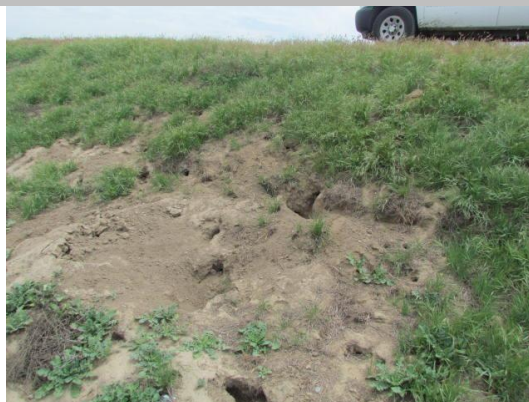
Photo 1 of 1 : SP_2015_NA0010_139_5_20150309_00003.jpg

LM Start	5.68	Rating **	M	Issue No.	5
LM End	5.68	Issue Type +	Ma	Location *	WS
Category	Earthen Levee			GPS Latitude/Longitude	
				Start	End
Item	Animal Control			36.791981 °	36.791981 °
				-120.206274 °	-120.206274 °
DWR ID	DWR_NA0010_23_s_2012_5				
Action/Comments					
Exterminate rodents and backfill and compact or grout burrows. Inspector Comments: Several large rodent holes in this area.

Looking at several rodent holes on landside slope.

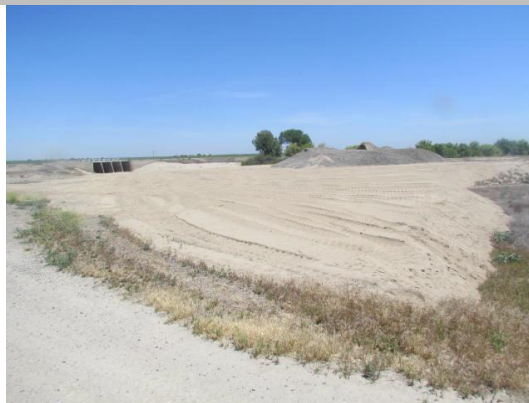
Photo 1 of 2 : SP_2015_NA0010_140_47_20150309_00005.jpg

LM Start	0.06	Rating **	M	Issue No.	47
LM End	0.06	Issue Type +	En	Location *	LS
Category	Earthen Levee			GPS Latitude/Longitude	
				Start	End
Item	Encroachments			36.772328 °	36.772328 °
				-120.285117 °	-120.285117 °
DWR ID	DWR_NA0010_24_s_2014_47				
Action/Comments					
Material					
Inspector Comments: District constructed a berm on waterward slope.					
Berm is being used for staging of earthen material.

Looking south at berm on waterward slope.

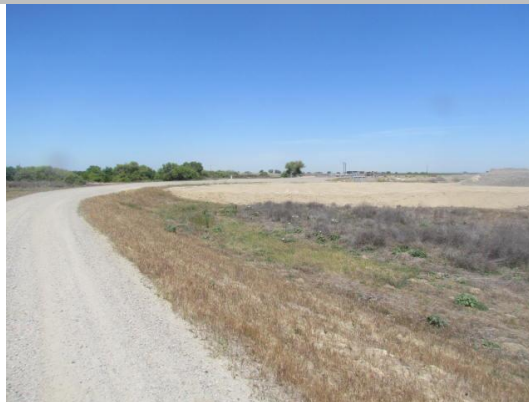
Photo 2 of 2 : SP_2015_NA0010_140_47_20150309_00006.jpg

LM Start	0.06	Rating **	M	Issue No.	47 (cont)
LM End	0.06	Issue Type +	En	Location *	LS

Looking north at berm on waterward slope.

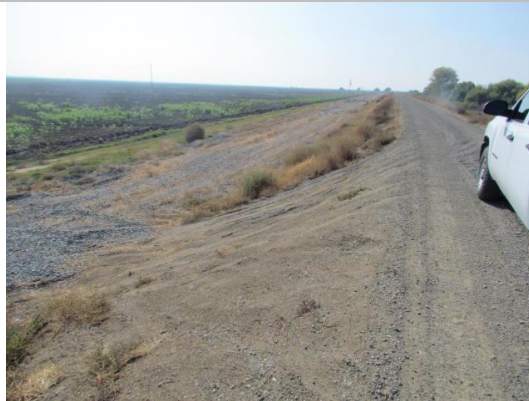
Photo 1 of 1 : SP_2015_NA0010_140_13_20150309_00004.jpg

LM Start	1.25	Rating **	A/W	Issue No.	13
LM End	1.25	Issue Type +	Ma	Location *	LS
Category	Earthen Levee			GPS Latitude/Longitude	
				Start	End
Item	Slope Stability			36.771834 °	36.771834 °
				-120.274224 °	-120.274224 °
DWR ID	DWR_NA0010_24_f_2014_13				
Action/Comments					
Repair the levee slope damaged by vehicle traffic and prevent access where possible.					
Inspector Comments: Slope damage due to vehicle traffic.

Looking north at slope damage by vehicle traffic on landward slope.

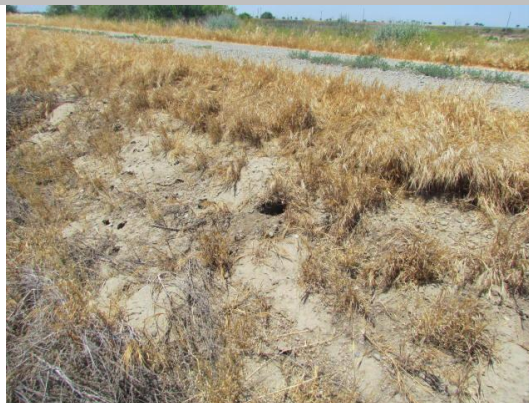
Photo 1 of 1 : SP_2015_NA0010_140_7_20150309_00003.jpg

LM Start	3.46	Rating **	M	Issue No.	7
LM End	3.46	Issue Type +	Ma	Location *	LS
Category	Earthen Levee			GPS Latitude/Longitude	
				Start	End
Item	Animal Control			36.769345 °	36.769345 °
				-120.238370 °	-120.238370 °
DWR ID	DWR_NA0010_24_s_2012_7				
Action/Comments					
No rodents visible, but rodent burrows visible; need to backfill and compact or grout burrows. Inspector Comments: One of several rodent holes on landward slope.

Looking east at one of several rodent holes on landward slope.

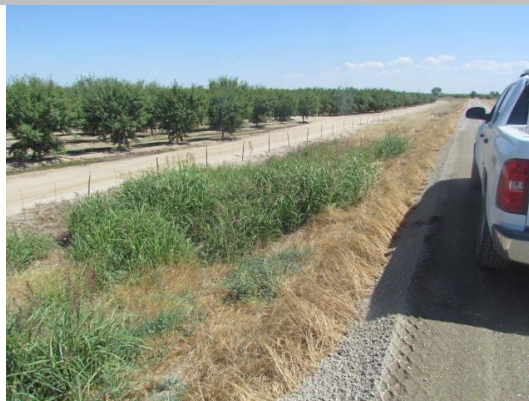
Photo 1 of 1 : SP_2015_NA0010_140_268_20150528_00071.jpg

LM Start	4.50	Rating **	M	Issue No.	268
LM End	4.50	Issue Type +	Ma	Location *	LS
Category	Earthen Levee			GPS Latitude/Longitude	
				Start	End
Item	Vegetation			36.775118 °	36.775118 °
				-120.231114 °	-120.231114 °
DWR ID	DWR_NA0010_24_s_2015_268				
Action/Comments					
Remove the wild growth other than native grasses from the levee slopes.					
Inspector Comments: Control Johnson Grass on landward toe and berm.

Looking south at Johnson Grass at landward toe and berm.

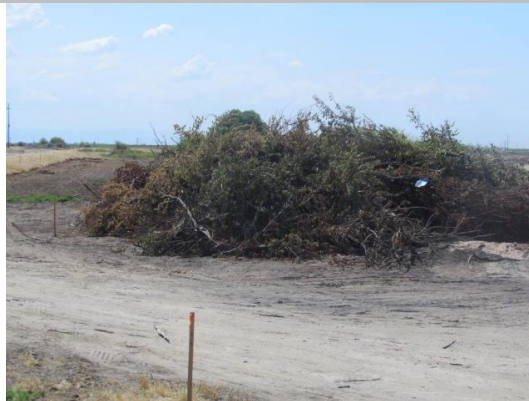
Photo 1 of 3 : SP_2015_NA0010_140_3_20150528_00073.jpg

LM Start	6.33	Rating **	M	Issue No.	3 (cont)
LM End	6.33	Issue Type +	Ma	Location *	WS

Looking northeast at pruning pile on waterward berm. (Spring 2015)

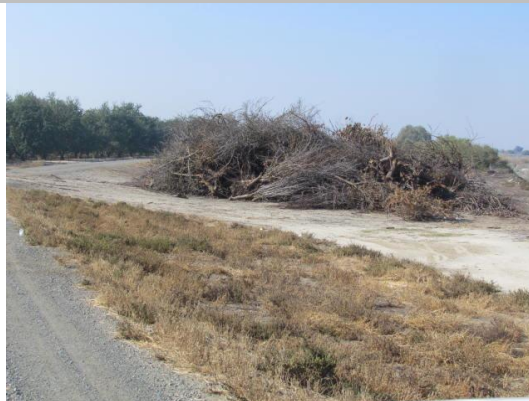
Photo 2 of 3 : SP_2015_NA0010_140_3_20150309_00001.jpg

Looking north at large pruning pile in channel. (Spring 2014)

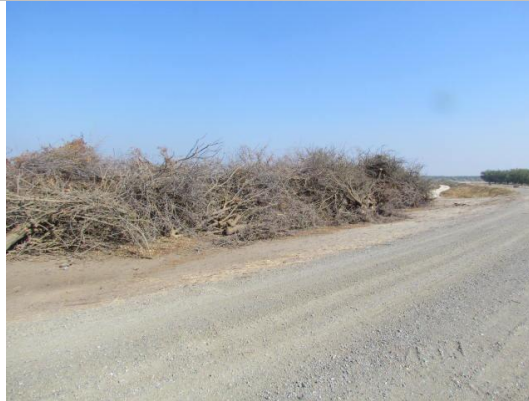
Photo 3 of 3 : SP_2015_NA0010_140_3_20150309_00002.jpg

Looking south at large pruning pile in channel. (Spring 2013)

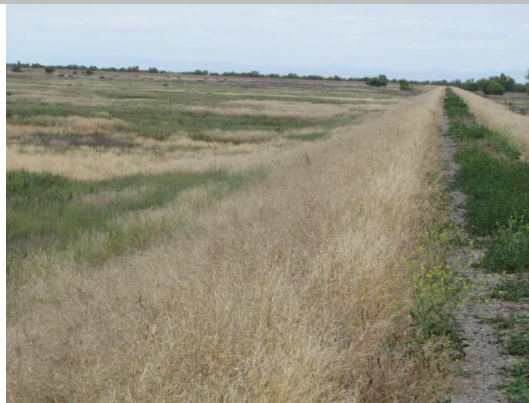
Photo 1 of 1 : SP_2015_NA0010_141_48_20150528_00003.jpg

Action/Comments					
Control annual grass and weeds on the levee slopes and easements. Inspector Comments: Control dense growth on waterward slope. Vegetation blocking view of slope.

Looking north at dense growth on landward slope.

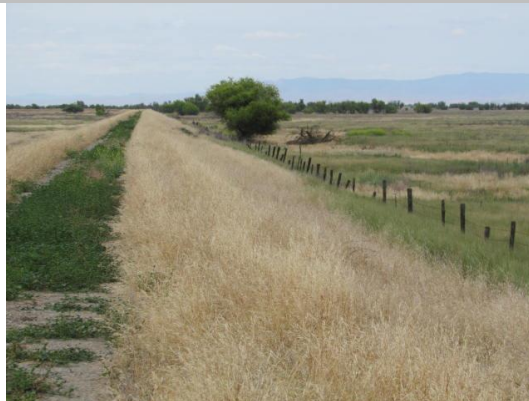
Photo 1 of 1 : SP_2015_NA0010_141_49_20150528_00004.jpg

LM Start	0.00	Rating **	U	Issue No.	49
LM End	2.49	Issue Type +	Ma	Location *	WS
Category	Earthen Levee			GPS Latitude/Longitude	
				Start	End
Item	Vegetation			37.296314 °	37.271097 °
				-120.880559 °	-120.866570 °
DWR ID	DWR_NA0010_25_s_2015_49				
Action/Comments					
Control annual grass and weeds on the levee slopes and easements. Inspector Comments: Control dense growth on landward slope. Vegetation blocking view of slope.

Looking north at dense growth on waterward slope.

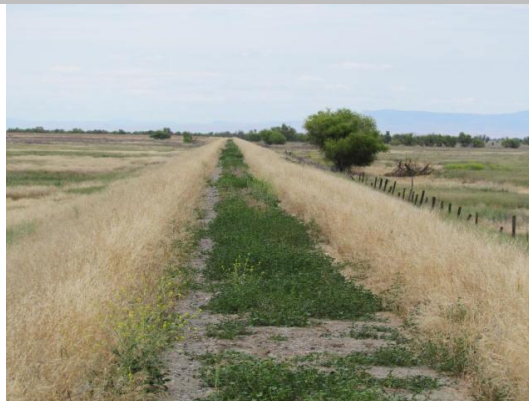
Photo 1 of 1 : SP_2015_NA0010_141_8_20150528_00005.jpg

LM Start	0.01	Rating **	M	Issue No.	8
LM End	2.48	Issue Type +	Ma	Location *	CR
Category	Earthen Levee			GPS Latitude/Longitude	
				Start	End
Item	Crown Surface / Depressions / Rutting			37.296117 °	37.271193 °
				-120.880724 °	-120.866633 °
DWR ID	DWR_NA0010_25_s_2012_8				
Action/Comments					
Add appropriate material and re-grade the levee to bring the crown above the design elevation.					
Inspector Comments: Control weeds on levee crown.

Looking north at growth on levee crown.
