**Flood Control Project Maintenance
Levee Inspections****LMA District Cover Sheet****Spring 2016 Levee Inspection Results****Lower San Joaquin Levee District**

Spring 2016 Levee Inspection Results

Lower San Joaquin Levee District

Waterway			Bank	Unit Miles
Unit No. 01 San Joaquin River			Right	22.52
	Spring (March - May)	Summer (June - August)	(September - November) Fall	Winter (December - February)
Unit Maintenance Rating (Fall Only)				
Date of Inspection	5/16/2016 - 5/19/2016			
DWR Inspector	Richard Willoughby			
Accompanied By

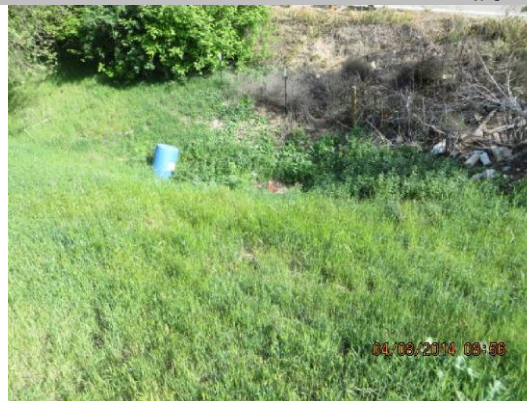
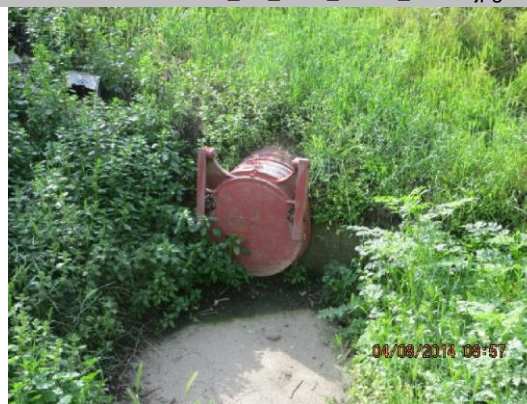
Photo 1 of 2 : UCIP_SP_2016_39091_60601.jpg

FS_ID:39091
DS_ID:19650
EP_NO: N/A
Repair Type: Non-Urgent
Crossing Status: Found
UCIP Comments: Dense vegetation limits the inspector's visibility to identify signs of pipe failure (leaks) along the waterward slope and landward toe. Recommend removing vegetation along pipe alignment and landward toe to conduct proper inspection of structure and appurtenances.
FIELD_STRUCT_DESC: 24-inch CM stormdrain pipe through the levee, 10.5 feet below the crown. Flap gate on the waterward end. Brass cap No. 108 BM on headwall on the landward side. (USACE-1967). This entry matches the Drainage or Irrigation Structure referenced in O&M manual (HLM 0.02).
FS Date: 4/8/2014 7:34:00 AM

LM Start	0.00	Rating **	M	Issue No.	1213 (cont)
LM End	0.00	Issue Type +	En	Location *	WS

Flapgate on WS toe.

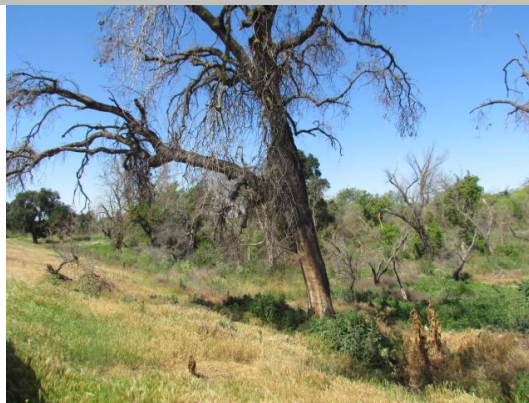
Photo 1 of 1 : SP_2016_NA0010_118_7_20160523_00232.jpg

LM Start	0.14	Rating **	U	Issue No.	7
LM End	0.14	Issue Type +	Ma	Location *	WS
Category	Earthen Levee			GPS Latitude/Longitude	
				Start	End
Item	Vegetation			37.347152 °	37.347152 °
				-120.960560 °	-120.960560 °
DWR ID	DWR_NA0010_01_s _ 2012_7				
Comment Code					
V7 : Trees / Woody Vegetation					
Inspector Comment					
Dead tree on waterward slope and toe.

Looking southwest at dead tree on landward slope and toe.

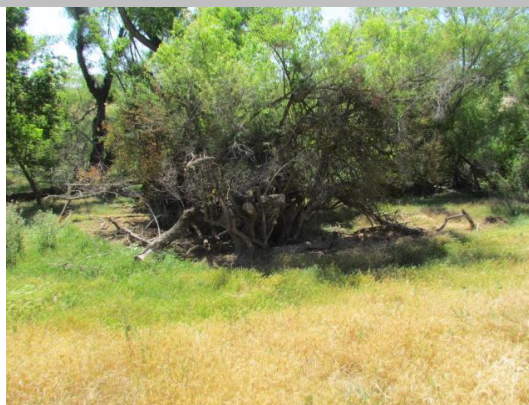
Photo 1 of 1 : SP_2016_NA0010_118_3_20160523_00233.jpg

LM Start	0.19	Rating **	M	Issue No.	3
LM End	0.19	Issue Type +	Ma	Location *	LS
Category	Earthen Levee			GPS Latitude/Longitude	
				Start	End
Item	Trim / Thin Trees			37.346576 °	37.346576 °
				-120.961061 °	-120.961061 °
DWR ID	DWR_NA0010_01_s _ 2016_3				
Comment Code					
T2 : Thin trees to allow visibility of the ground and room to flood fight.					
Inspector Comment					
Dead tree (limbs & branches) blocking landward right of way/ berm.

Looking east at brush and tree limbs blocking landward toe.

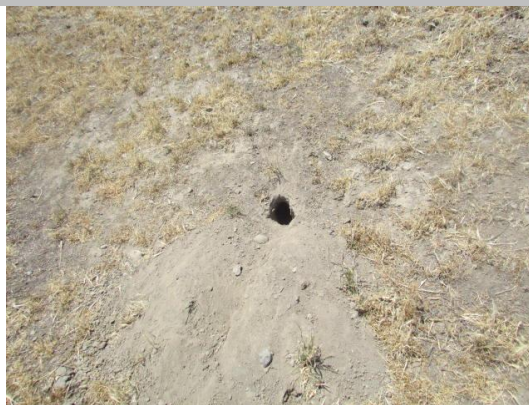
Photo 1 of 1 : SP_2016_NA0010_118_1_20160512_00001.jpg

LM Start	0.23	Rating **	M	Issue No.	1
LM End	0.23	Issue Type +	Ma	Location *	LS
Category	Earthen Levee			GPS Latitude/Longitude	
				Start	End
Item	Animal Control			37.346096 °	37.346096 °
				-120.961455 °	-120.961455 °
DWR ID	DWR_NA0010_01_s _ 2012_1				
Comment Code					
A1 : Exterminate rodents and backfill and compact or grout burrows.					
Inspector Comment					
Typical view of several rodent holes on landward slope.

Looking at typical rodent holes on landward slope.

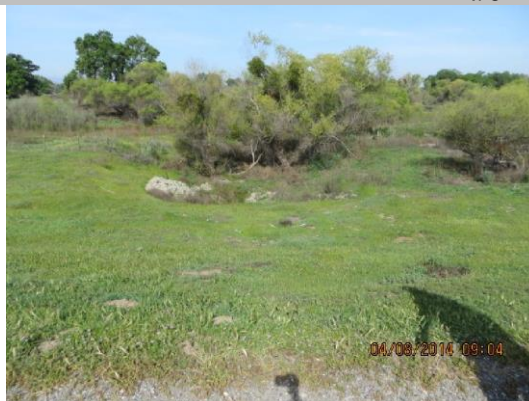
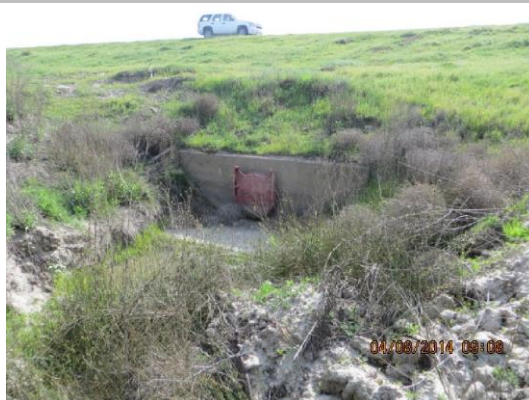
Photo 1 of 2 : UCIP_SP_2016_39092_60611.jpg

LM Start	0.34	Rating **	M	Issue No.	1214
LM End	0.34	Issue Type +	En	Location *	LS
Category	Supplemental			GPS Latitude/Longitude	
				Start	End
Item	DWR UCIP Field Study			37.344705 °	37.344705 °
				-120.962176 °	-120.962176 °
DWR ID					
Comment Code					
Inspector Comment					
FS_ID:39092					
DS_ID:19651					
EP_NO: N/A					
Repair Type: Non-Urgent					
Crossing Status: Found					
UCIP Comments: Pipe has significant sediment buildup and shows some signs of corrosion at landward toe. Recommend cleaning sediment from inside pipe and check wall integrity.					
FIELD_STRUCT_DESC: 36-inch CM stormdrain pipe through the levee, 18.5 feet below the crown. Flap gate on the waterward end. Brass cap No. 108 BM on headwall on the landward side. (USACE-1967). This entry matches the Drainage or Irrigation Structure referenced in O&M manual (HLM 0.35).					
FS Date: 4/8/2014

Flapgate and headwall visible off WS toe.

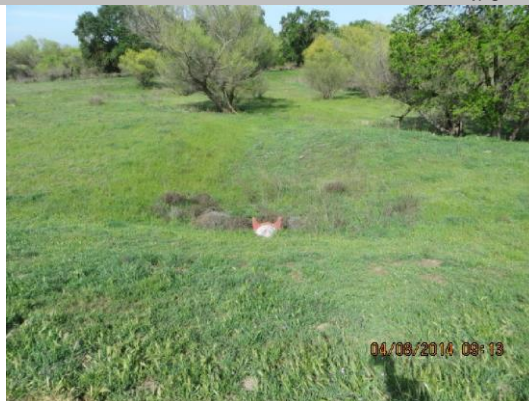
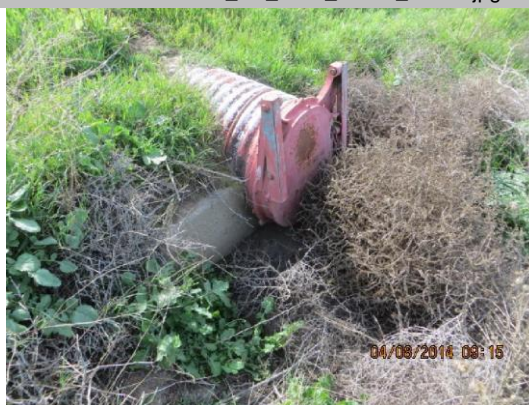
Photo 1 of 2 : UCIP_SP_2016_39095_60622.jpg

LM Start	0.60	Rating **	M	Issue No.	1215
LM End	0.60	Issue Type +	En	Location *	LS
Category	Supplemental			GPS Latitude/Longitude	
				Start	End
Item	DWR UCIP Field Study			37.341507 °	37.341507 °
				-120.961283 °	-120.961283 °
DWR ID					
Comment Code					
Inspector Comment					
FS_ID:39095 DS_ID:19583 EP_NO: N/A Repair Type: Non-Urgent Crossing Status: Found UCIP Comments: Recommend removing vegetation pile from waterward toe. FIELD_STRUCT_DESC: 24-inch CM stormdrain pipe through the levee, 8.5 feet below the crown. Flap gate on the waterward end. Brass cap No. 108 BM on headwall on the landward side. (USACE-1967). This entry matches the Drainage or Irrigation Structure referenced in O&M manual (HLM 0.62). FS Date: 4/8/2014

Flapgate and headwall visible on WS toe.

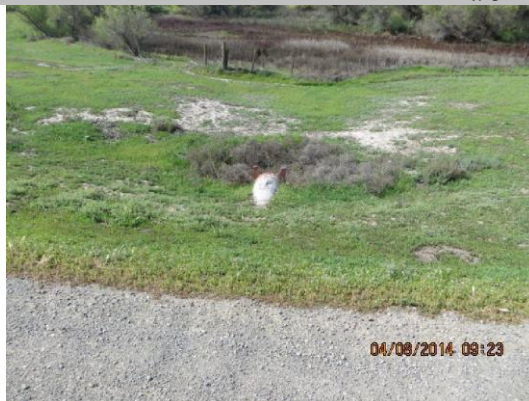
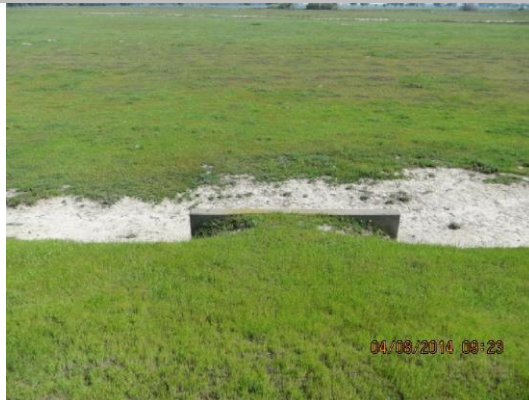
Photo 1 of 2 : UCIP_SP_2016_39096_60632.jpg

LM Start	0.93	Rating **	M	Issue No.	1216
LM End	0.93	Issue Type +	En	Location *	LS
Category	Supplemental			GPS Latitude/Longitude	
				Start	End
Item	DWR UCIP Field Study			37.339598 °	37.339598 °
				-120.957202 °	-120.957202 °
DWR ID					
Comment Code					
Inspector Comment					
FS_ID:39096 DS_ID:19585 EP_NO: N/A Repair Type: Non-Urgent Crossing Status: Found UCIP Comments: Moderate erosion around headwall on landward toe. May or may not be an issue. Need to contact owner to determine status of crossing and to address erosion issue on landward side. FIELD_STRUCT_DESC: 24-inch CM pipe through the levee, 7-feet below the crown. Flap gate on the waterward end. Brass cap No. 108 BM on headwall on the landward side. (USACE-1967). This entry matches the Drainage or Irrigation Structure referenced in O&M manual (HLM 0.95). FS Date: 4/8/2014

Flapgate, pipe, and headwall on WS toe.

Concrete headwall and pipe visible at LS toe.

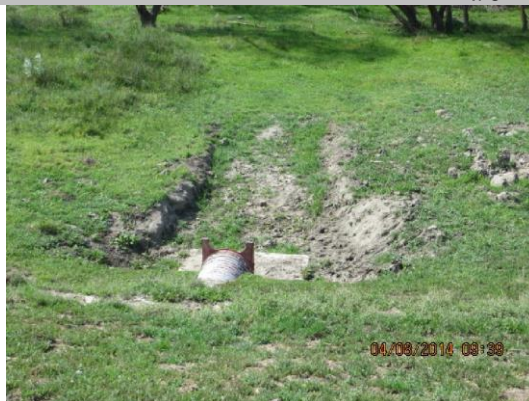
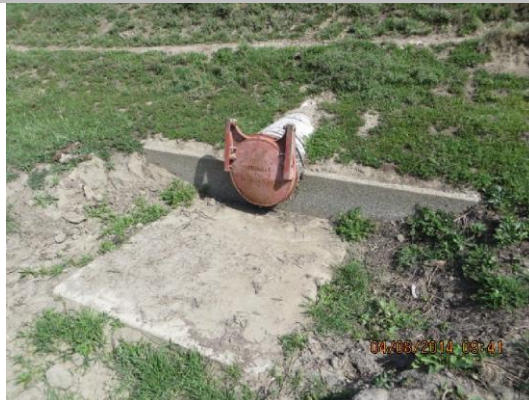
Photo 1 of 2 : UCIP_SP_2016_39099_60652.jpg

LM Start	1.46	Rating **	M	Issue No.	1217
LM End	1.46	Issue Type +	En	Location *	LS
Category	Supplemental			GPS Latitude/Longitude	
				Start	End
Item	DWR UCIP Field Study			37.336866 °	37.336866 °
				-120.948520 °	-120.948520 °
DWR ID					
Comment Code					
Inspector Comment					
FS_ID:39099					
DS_ID:19588					
EP_NO: N/A					
Repair Type: Non-Urgent					
Crossing Status: Found					
UCIP Comments: Some sediment buildup inside pipe at LS toe.					
Recommend contacting owner to clear sediment buildup and check wall integrity through pipe section.					
FIELD_STRUCT_DESC: 24-inch CM stormdrain pipe through the levee, 11.0 feet below the crown. Flap gate on the waterward end. Brass cap No. 108 BM on headwall on the landward side. (USACE-1967). This entry matches the Drainage or Irrigation Structure referenced in O&M manual (HLM 1.48).					
FS Date: 4/8/2014

Pipe, flapgate, and concrete headwall visible on WS toe.

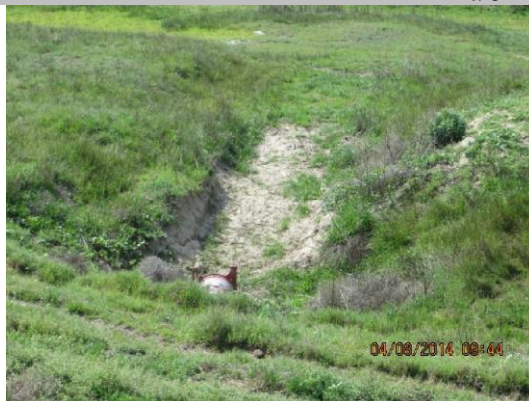
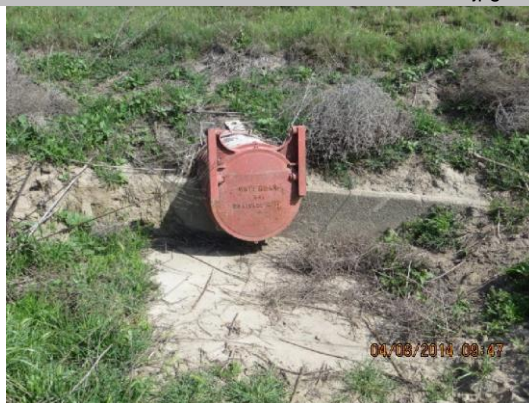
Photo 1 of 2 : UCIP_SP_2016_33563_60661.jpg

LM Start	1.67	Rating **	M	Issue No.	1185
LM End	1.67	Issue Type +	En	Location *	LS
Category	Supplemental			GPS Latitude/Longitude	
				Start	End
Item	DWR UCIP Field Study			37.336459 °	37.336459 °
				-120.944803 °	-120.944803 °
DWR ID					
Comment Code					
Inspector Comment					
FS_ID:33563 DS_ID:19589 EP_NO: N/A Repair Type: Non-Urgent Crossing Status: Found UCIP Comments: Heavy sediment buildup in pipe at LS toe. FIELD_STRUCT_DESC: 24-inch CM stormdrain pipe through the levee, 13.6 feet below the crown. Flap gate on the waterward end. Brass cap No. 100 BM on headwall on the landward side. (USACE-1967). This entry matches the Drainage or Irrigation Structure referenced in O&M manual (HLM 1.69). FS Date: 4/8/2014

Pipe, headwall, and flapgate visible on WS toe.

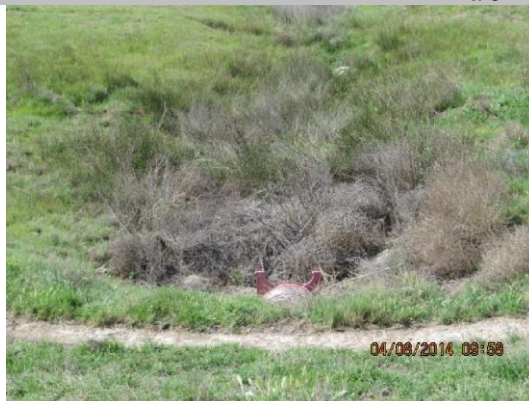
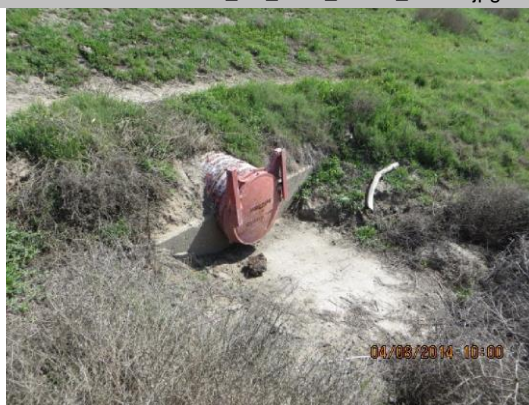
Photo 1 of 2 : UCIP_SP_2016_39100_60670.jpg

LM Start	1.95	Rating **	M	Issue No.	1218
LM End	1.95	Issue Type +	En	Location *	LS
Category	Supplemental			GPS Latitude/Longitude	
				Start	End
Item	DWR UCIP Field Study			37.334377 °	37.334377 °
				-120.940397 °	-120.940397 °
DWR ID					
Comment Code					
Inspector Comment					
FS_ID:39100 DS_ID:19591 EP_NO: N/A Repair Type: Non-Urgent Crossing Status: Found UCIP Comments: Need to contact owner to determine crossing status. Inlet drop box silted in and needs to be cleaned out. FIELD_STRUCT_DESC: 24-inch CM stormdrain pipe through the levee, 9.7 feet below the crown. Flap gate on the waterward end. Brass cap No. 100 BM on headwall on the landward side. (USACE-1967). Wooden barrier around drop inlet on LS toe. This entry matches the Drainage or Irrigation Structure referenced in O&M manual (HLM 1.98). FS Date: 4/8/2014

Concrete headwall and flapgate on WS toe.

Pipe, flapgate, and headwall on WS toe.

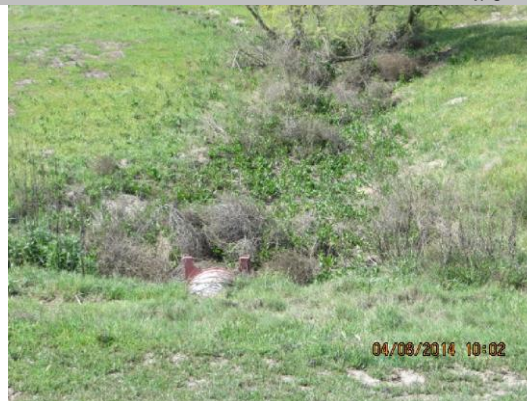
Photo 1 of 2 : UCIP_SP_2016_39123_60675.jpg

LM Start	2.06	Rating **	M	Issue No.	1219
LM End	2.06	Issue Type +	En	Location *	LS
Category	Supplemental			GPS Latitude/Longitude	
				Start	End
Item	DWR UCIP Field Study			37.333653 °	37.333653 °
				-120.938770 °	-120.938770 °
DWR ID					
Comment Code					
Inspector Comment					
FS_ID:39123 DS_ID:19570 EP_NO: N/A Repair Type: Non-Urgent Crossing Status: Found UCIP Comments: Unable to find inlet on landward toe. Recommend clearing vegetation on landward side to properly inspect inlet. FIELD_STRUCT_DESC: 24-inch CM stormdrain pipe through the levee, 9.8 feet below the crown. Flap gate on waterward end. Brass cap No. 100 BM on headwall on the landward side. (USACE-1967). This entry matches the Drainage or Irrigation Structure referenced in O&M manual (HLM 2.08). FS Date: 4/8/2014

Pipe and flapgate visible on WS toe.

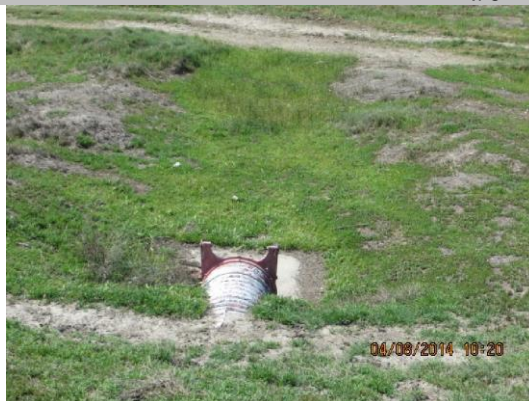
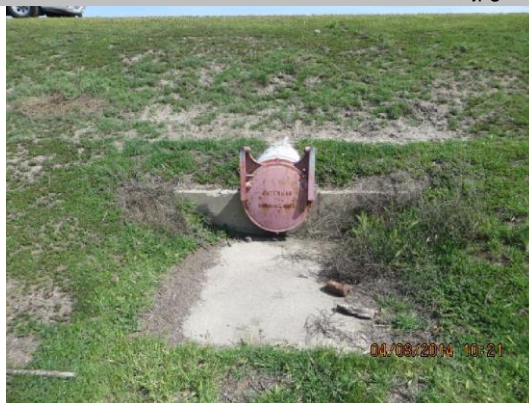
Photo 1 of 2 : UCIP_SP_2016_39127_60688.jpg

LM Start	2.67	Rating **	M	Issue No.	1220
LM End	2.67	Issue Type +	En	Location *	LS
Category	Supplemental			GPS Latitude/Longitude	
				Start	End
Item	DWR UCIP Field Study			37.327362 °	37.327362 °
				-120.931591 °	-120.931591 °
DWR ID					
Comment Code					
Inspector Comment					
FS_ID:39127 DS_ID:19573 EP_NO: N/A Repair Type: Non-Urgent Crossing Status: Found UCIP Comments: Sedimentation in pipe at landward toe. FIELD_STRUCT_DESC: 24-inch CM stormdrain pipe through the levee, 7.3 feet below the crown. Flap gate on the waterward end. Brass cap No. 100 BM on headwall on the landward side. (USACE-1967). This entry matches the Drainage or Irrigation Structure referenced in O&M manual (HLM 2.70). FS Date: 4/8/2014

Pipe, flapgate, and headwall on WS toe.

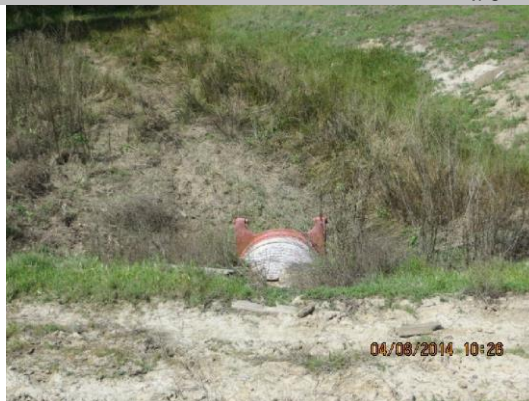
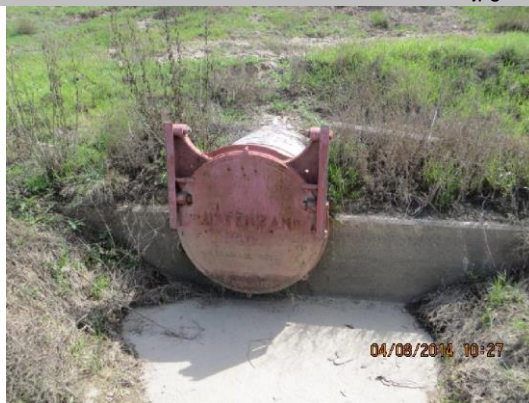
Photo 1 of 2 : UCIP_SP_2016_39128_60702.jpg

LM Start	3.13	Rating **	M	Issue No.	1221
LM End	3.13	Issue Type +	En	Location *	LS
Category	Supplemental			GPS Latitude/Longitude	
				Start	End
Item	DWR UCIP Field Study			37.321444 °	37.321444 °
				-120.928764 °	-120.928764 °
DWR ID					
Comment Code					
Inspector Comment					
FS_ID:39128					
DS_ID:19574					
EP_NO: N/A					
Repair Type: Non-Urgent					
Crossing Status: Found					
UCIP Comments: Some minor erosion around headwall on LS toe.					
FIELD_STRUCT_DESC: 36-inch CM pipe through the levee, 8-feet below the crown. Flap gate on the waterward end. Brass cap No. 100					
BM on headwall on the landward side. (USACE-1967). This entry matches the Drainage or Irrigation Structure referenced in O&M manual (HLM 3.16).					
FS Date: 4/8/2014

Pipe, Flapgate, and headwall on WS toe.

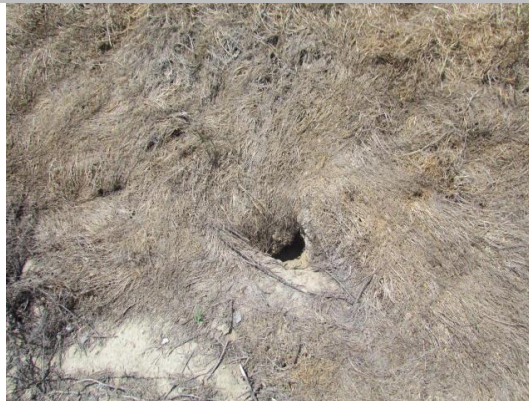
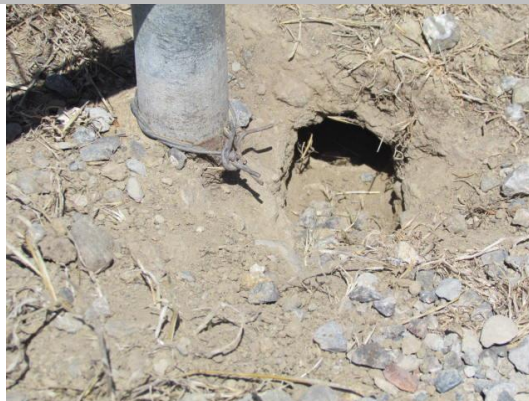
Photo 1 of 2 : SP_2016_NA0010_118_10_20160512_00008.jpg

LM Start	3.16	Rating **	M	Issue No.	10
LM End	3.16	Issue Type +	Ma	Location *	LS
Category	Earthen Levee			GPS Latitude/Longitude	
				Start	End
Item	Animal Control			37.321053 °	37.321053 °
				-120.928785 °	-120.928785 °
DWR ID	DWR_NA0010_01_s _ 2012_10				
Comment Code					
A3 : No rodents visible, but rodent burrows visible; need to backfill and compact or grout burrows.					
Inspector Comment					
Several rodent holes noted in this section. Rodent hole noted on waterward shoulder next fence pole.

Looking at typical view of rodent holes on landward slope.

Looking at rodent hole next to fence pole on landward shoulder.

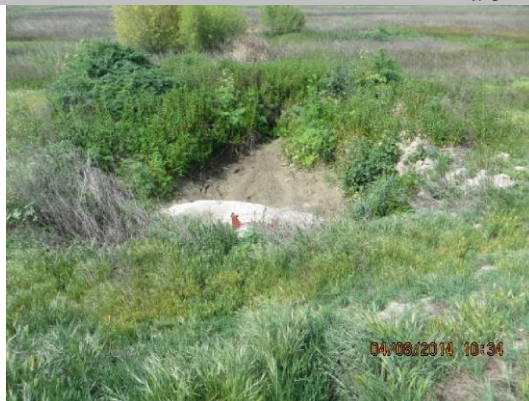
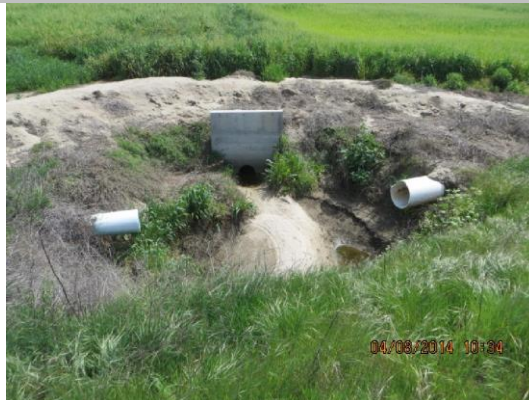
Photo 1 of 2 : UCIP_SP_2016_39130_60707.jpg

FS_ID:39130
DS_ID:19575
EP_NO: N/A
Repair Type: Urgent
Crossing Status: Found
UCIP Comments: Pipe rusted through at Springline on LS toe. Flapgate blocked by sediment on WS toe. Heavy sediment on both ends of pipe. Need to contact owner to address issues.
FIELD_STRUCT_DESC: 36-inch CM pipe, through the levee, 9.7 feet below the crown. Flap gate on the waterward end. Brass cap No. 100 BM on headwall on the landward side. (USACE-1967). This entry matches the Drainage or Irrigation Structure referenced in O&M manual (HLM 3.50).
FS Date: 4/8/2014

Pipe, headwall, and flapgate on WS toe.

Pipe and headwall on LS toe.

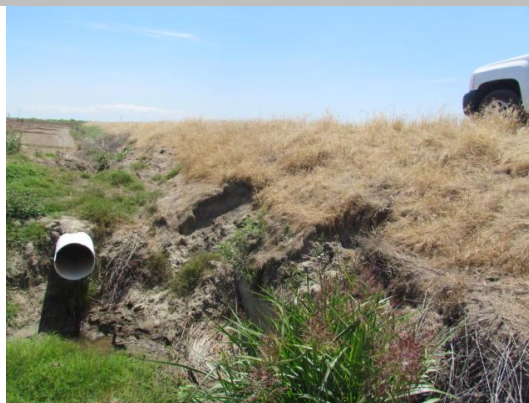
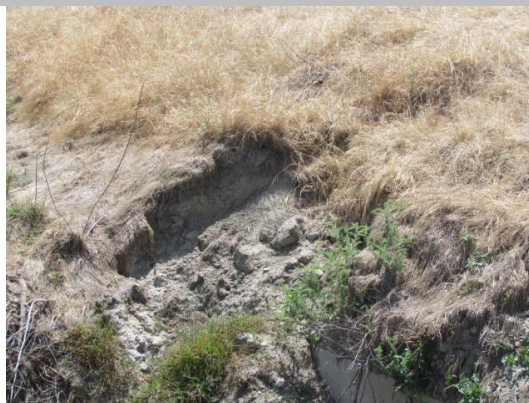
Photo 1 of 3 : SP_2016_NA0010_118_1179_20160512_00025.jpg

Looking south at erosion on landward slope and toe.

Looking southwest at erosion on landward slope and toe.

Looking west at erosion on landward slope and toe.

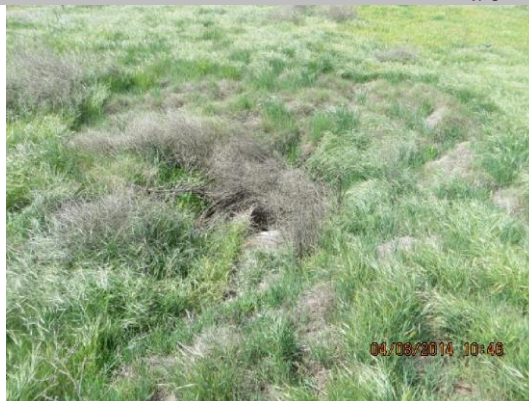
Photo 1 of 2 : UCIP_SP_2016_39132_60723.jpg

Comment Code					
Inspector Comment					
FS_ID:39132 DS_ID:19576 EP_NO: N/A Repair Type: Non-Urgent Crossing Status: Found UCIP Comments: Slide gate missing from WS. No closure device, but degrading of levee at Highway 140 is lower than pipe, so this does not appear to be a critical issue. Also dense vegetation limits the inspector's visibility to identify signs of pipe failure (leaks) along the slope. Recommend removing vegetation along pipe alignment to conduct proper inspection of structure and appurtenances. FIELD_STRUCT_DESC: 30-inch CM irrigation pipe through the levee, 3.5 feet below the crown. Slidegate on the waterward end. Brass cap No. 100 BM on headwall on the landward side. (USACE-1967). This entry matches the Drainage or Irrigation Structure referenced in O&M manual (HLM 3.95). FS Date: 4/8/2014

Slide gate missing on WS toe with heavy vegetation camouflaging pipe

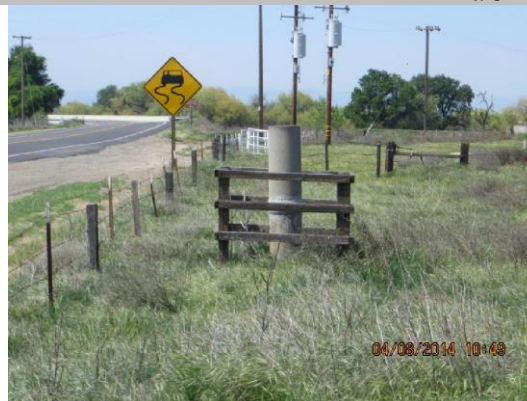
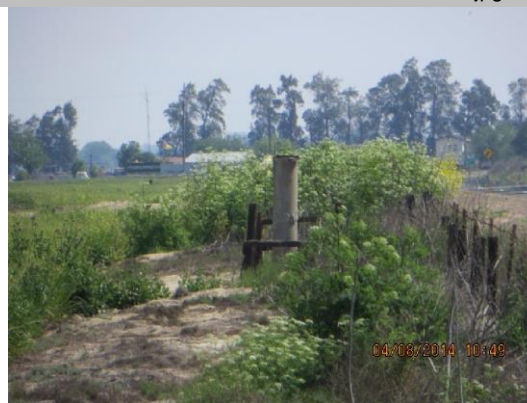
Photo 1 of 2 : UCIP_SP_2016_39133_60725.jpg

FS_ID:39133
DS_ID:19606
EP_NO: N/A
Repair Type: Non-Urgent
Crossing Status: Indicator Found
UCIP Comments: Need to contact owner to determine status of crossing inlet and outlet not found.
FIELD_STRUCT_DESC: 12-inch concrete irrigation pipe through the levee, 3.5 feet below the crown. 12-inch Concrete standpipes off both sides of levee.
FS Date: 4/8/2014

12-inch concrete standpipe off WS toe.

12-inch concrete standpipe off LS toe.

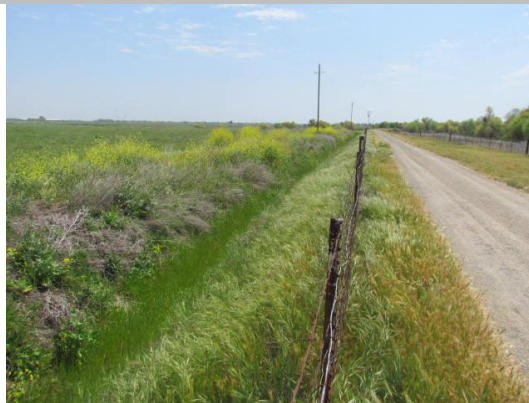
Photo 1 of 2 : SP_2016_NA0010_118_5_20160512_00002.jpg

LM Start	3.98	Rating **	U	Issue No.	5 (cont)
LM End	4.05	Issue Type +	En	Location *	LS

Looking north at irrigation ditch at landside toe.

Looking south at irrigation ditch at landside toe.

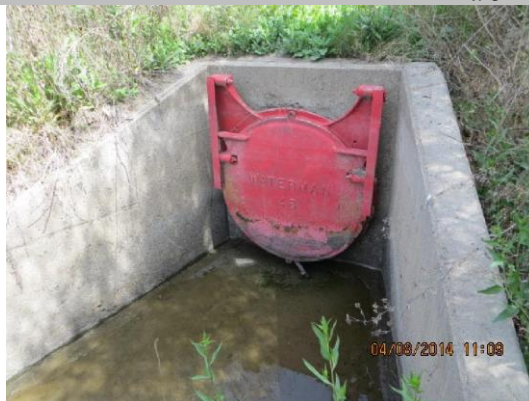
Photo 1 of 2 : UCIP_SP_2016_39134_60730.jpg

Comment Code						
Inspector Comment						
FS_ID:39134 DS_ID:19607 EP_NO: N/A Repair Type: Non-Urgent Crossing Status: Found UCIP Comments: Pipe appears sleeved with a 12-inch steel pipe with a slide gate at the LS toe. No identified authorization for changes to this crossing. Need to contact owner to obtain additional information about the modifications to crossing. FIELD_STRUCT_DESC: 48-inch CM stormdrain pipe through the levee, 14.0 feet below the crown. Flap gate on the waterward end. Brass cap No. 90 BM on headwall on the landward side. (USACE-1967). This entry matches the Drainage or Irrigation Structure referenced in O&M manual (HLM 4.16). FS Date: 4/8/2014

Concrete headwall and 48-inch flapgate visible on WS toe.

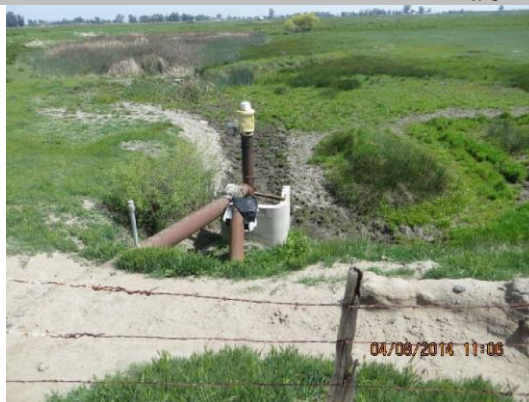
Photo 2 of 2 : UCIP_SP_2016_39134_60731.jpg

Assumed pipe exists under pump at LS toe.

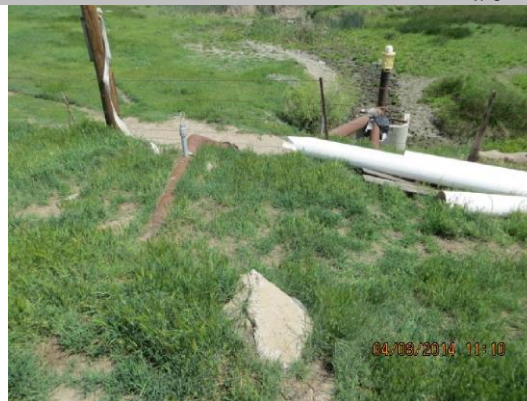
Photo 1 of 2 : UCIP_SP_2016_39138_71320.jpg

LM Start	4.13	Rating **	M	Issue No.	1187
LM End	4.13	Issue Type +	En	Location *	LS
Category	Supplemental			GPS Latitude/Longitude	
				Start	End
Item	DWR UCIP Field Study			37.309063 °	37.309063 °
				-120.924449 °	-120.924449 °
DWR ID					
Comment Code					
Inspector Comment					
FS_ID:39138 DS_ID:24866 EP_NO: N/A Repair Type: Non-Urgent Crossing Status: Found UCIP Comments: Need to contact owner to get details of crossing. FIELD_STRUCT_DESC: 12-inch steel stormdrain pipe through the levee 2.5-feet below the crown. 12-inch steel pipe, vent, and pump on stand visible on LS slope. 10-inch PVC pipe visible on WS slope. FS Date: 4/8/2014

View of pipe visible on landward side.

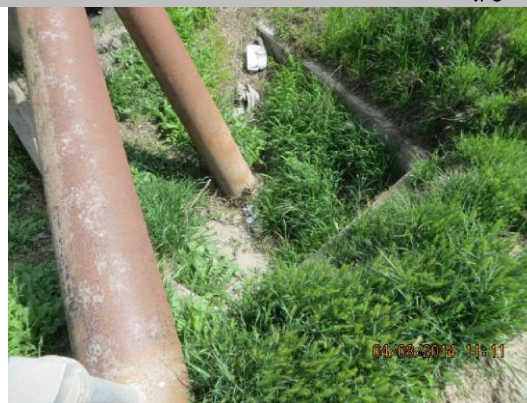
Photo 2 of 2 : UCIP_SP_2016_39138_71319.jpg

Pipe through existing 48 inch pipe.

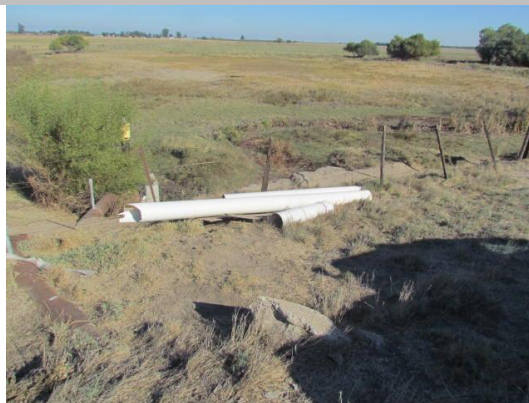
Photo 1 of 1 : SP_2016_NA0010_118_100_20160512_00018.jpg

LM Start	4.13	Rating **	M	Issue No.	100
LM End	4.13	Issue Type +	Ma	Location *	LS
Category	Earthen Levee			GPS Latitude/Longitude	
				Start	End
Item	Encroachments			37.309049 °	37.309049 °
				-120.924421 °	-120.924421 °
DWR ID	DWR_NA0010_01_f_2014_100				
Comment Code					
GA : Garbage					
Inspector Comment					
Old PVC pipes left on landward slope.

Looking east at old pvc pipes on landward slope.

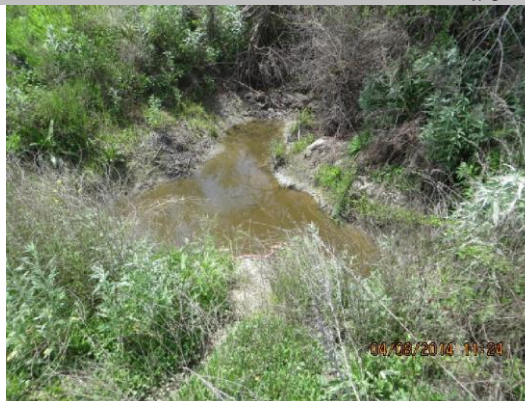
Photo 1 of 2 : UCIP_SP_2016_39140_60733.jpg

Comment Code					
Inspector Comment					
FS_ID:39140 DS_ID:19608 EP_NO: N/A Repair Type: Non-Urgent Crossing Status: Found UCIP Comments: Dense vegetation and fence limits the inspector's visibility to identify signs of pipe failure (leaks) along the landward side. Recommend obtaining access to landward toe and removing vegetation along pipe alignment to conduct proper inspection of structure and appurtenances. FIELD_STRUCT_DESC: 24-inch CM stormdrain pipe through the levee, 11.9 feet below the crown. Flap gate on the waterward end. Brass cap No. 90 BM on headwall on the landward side. (USACE-1967). This entry matches the Drainage or Irrigation Structure referenced in O&M manual (HLM 4.27). FS Date: 4/8/2014

Pipe, flapgate, and headwall visible at WS toe.

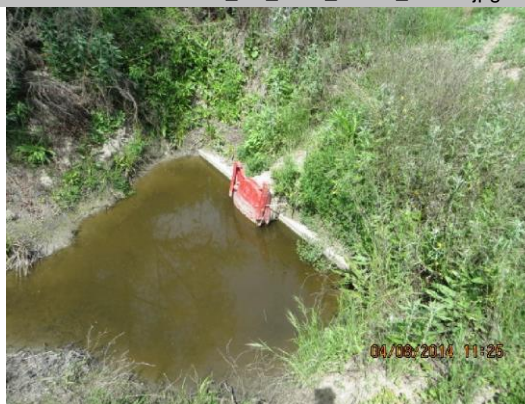
Photo 2 of 2 : UCIP_SP_2016_39140_60732.jpg

Pipe, flapgate, and headwall visible at WS toe.

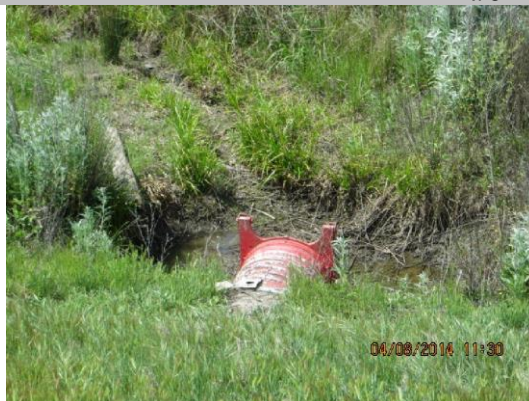
Photo 1 of 2 : UCIP_SP_2016_39141_60737.jpg

Comment Code						
Inspector Comment						
FS_ID:39141 DS_ID:19609 EP_NO: N/A Repair Type: Non-Urgent Crossing Status: Found UCIP Comments: Dense vegetation limits the inspector's visibility to identify signs of pipe failure (leaks) along the waterward side. Recommend removing vegetation along pipe alignment to conduct proper inspection of structure and appurtenances. FIELD_STRUCT_DESC: 24-inch CM stormdrain pipe through the levee, 10.0-feet below the crown. Flap gate on the waterward end. Brass cap No. 90 BM on headwall on the landward side. (USACE-1967). This entry matches the Drainage or Irrigation Structure referenced in O&M manual (HLM 4.72). FS Date: 4/8/2014

Pipe, flapgate, and headwall on WS toe.

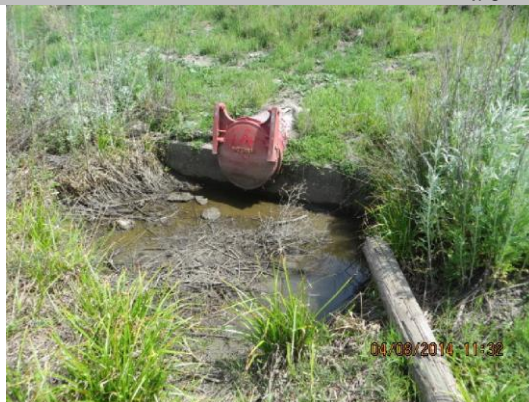
Photo 2 of 2 : UCIP_SP_2016_39141_60738.jpg

Pipe, flapgate, and headwall on WS toe.

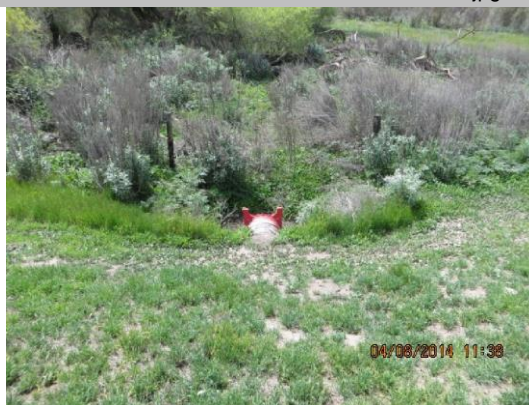
Photo 1 of 2 : UCIP_SP_2016_39143_60740.jpg

LM Start	5.02	Rating **	M	Issue No.	1190
LM End	5.02	Issue Type +	En	Location *	LS
Category	Supplemental			GPS Latitude/Longitude	
				Start	End
Item	DWR UCIP Field Study			37.298917 °	37.298917 °
				-120.917262 °	-120.917262 °
DWR ID					
Comment Code					
Inspector Comment					
FS_ID:39143 DS_ID:19610 EP_NO: N/A Repair Type: Non-Urgent Crossing Status: Found UCIP Comments: Non-functional -- sediment buildup against flapgate and inlet buried at landward side. FIELD_STRUCT_DESC: 24-inch CM stormdrain pipe through the levee, 8.0 feet below the crown. Flap gate on the waterward end. Brass cap No. 90 BM on headwall on the landward side. (USACE-1967). This entry matches the Drainage or Irrigation Structure referenced in O&M manual (HLM 5.05). FS Date: 4/8/2014

Flapgate and headwall visible at WS toe.

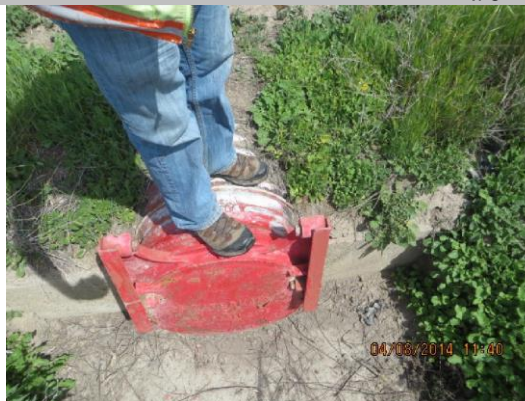
Photo 2 of 2 : UCIP_SP_2016_39143_60739.jpg

LM Start	5.02	Rating **	M	Issue No.	1190 (cont)
LM End	5.02	Issue Type +	En	Location *	LS
Category	Supplemental			GPS Latitude/Longitude	
				Start	End
Item	DWR UCIP Field Study			37.298917 °	37.298917 °
				-120.917262 °	-120.917262 °
DWR ID					
Comment Code					
Inspector Comment					
FS_ID:39143 DS_ID:19610 EP_NO: N/A Repair Type: Non-Urgent Crossing Status: Found UCIP Comments: Non-functional -- sediment buildup against flapgate and inlet buried at landward side. FIELD_STRUCT_DESC: 24-inch CM stormdrain pipe through the levee, 8.0 feet below the crown. Flap gate on the waterward end. Brass cap No. 90 BM on headwall on the landward side. (USACE-1967). This entry matches the Drainage or Irrigation Structure referenced in O&M manual (HLM 5.05). FS Date: 4/8/2014

Flapgate and headwall visible at WS toe.

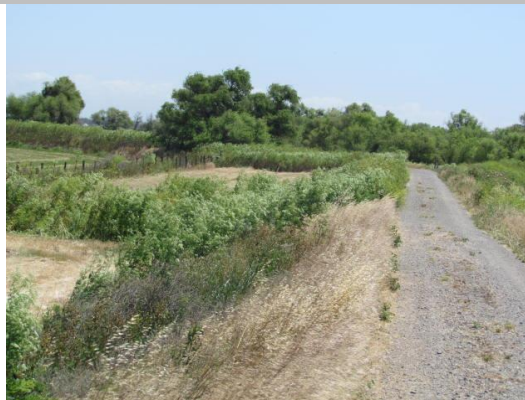
Photo 1 of 1 : SP_2016_NA0010_118_93_20160523_00235.jpg

LM Start	5.87	Rating **	U	Issue No.	93
LM End	6.86	Issue Type +	Ma	Location *	WS
Category	Earthen Levee			GPS Latitude/Longitude	
				Start	End
Item	Vegetation			37.302156 °	37.302156 °
				-120.888031 °	-120.888031 °
DWR ID	DWR_NA0010_01_f_2015_93				
Comment Code					
V2 : Remove the wild growth other than native grasses from the levee slopes.					
Inspector Comment

Looking south at dense veg on waterward slope.

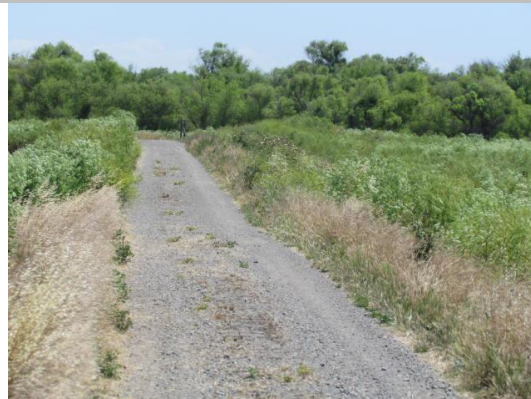
Photo 1 of 1 : SP_2016_NA0010_118_92_20160523_00236.jpg

LM Start	5.87	Rating **	U	Issue No.	92
LM End	6.86	Issue Type +	Ma	Location *	LS
Category	Earthen Levee			GPS Latitude/Longitude	
				Start	End
Item	Vegetation			37.303555 °	37.302156 °
				-120.904541 °	-120.888030 °
DWR ID	DWR_NA0010_01_f_2015_92				
Comment Code					
V2 : Remove the wild growth other than native grasses from the levee slopes.					
Inspector Comment

Looking south at dense veg on landward slope.

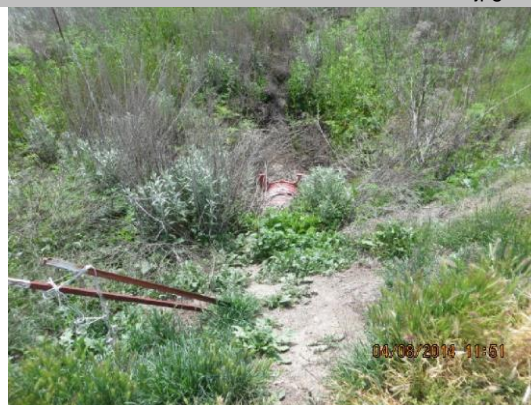
Photo 1 of 2 : UCIP_SP_2016_39151_60742.jpg

Comment Code					
Inspector Comment					
FS_ID:39151 DS_ID:19611 EP_NO: N/A Repair Type: Non-Urgent Crossing Status: Found UCIP Comments: Dense vegetation limits the inspector's visibility to identify signs of pipe failure (leaks) along waterward and landward slopes. Recommend removing vegetation along pipe alignment to conduct proper inspection of structure and appurtenances. Landward side filled in with soil. Need to contact owner. If crossing is no longer used need to coordinate with CVFPB for proper abandonment. FIELD_STRUCT_DESC: 24-inch CM stormdrain pipe through the levee, 8.6 feet below the crown. Flap gate on the waterward end. Brass cap No. 90 BM on headwall on the landward side. (USACE-1967). This entry matches the Drainage or Irrigation Structure referenced in O&M manual (HLM 5.95). FS Date: 4/8/2014

Pipe, concrete headwall, and flapgate visible on WS toe.

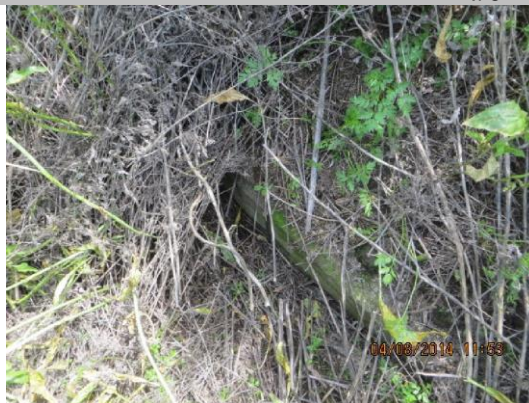
Photo 2 of 2 : UCIP_SP_2016_39151_60741.jpg

Item	DWR UCIP Field Study			37.303612 °		37.303612 °
				-120.903704 °		-120.903704 °
DWR ID						
Comment Code						
Inspector Comment						
FS_ID:39151 DS_ID:19611 EP_NO: N/A Repair Type: Non-Urgent Crossing Status: Found UCIP Comments: Dense vegetation limits the inspector's visibility to identify signs of pipe failure (leaks) along waterward and landward slopes. Recommend removing vegetation along pipe alignment to conduct proper inspection of structure and appurtenances. Landward side filled in with soil. Need to contact owner. If crossing is no longer used need to coordinate with CVFPB for proper abandonment. FIELD_STRUCT_DESC: 24-inch CM stormdrain pipe through the levee, 8.6 feet below the crown. Flap gate on the waterward end. Brass cap No. 90 BM on headwall on the landward side. (USACE-1967). This entry matches the Drainage or Irrigation Structure referenced in O&M manual (HLM 5.95). FS Date: 4/8/2014

Top of concrete headwall just visible on LS toe.

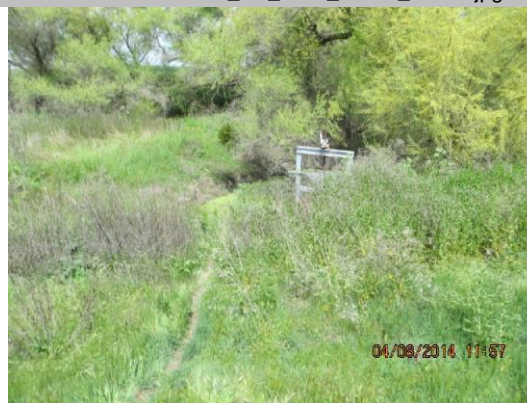
Photo 1 of 2 : UCIP_SP_2016_39152_60745.jpg

FS_ID:39152
DS_ID:19612
EP_NO: N/A
Repair Type: Non-Urgent
Crossing Status: Found
UCIP Comments: Dense vegetation limits the inspector's visibility to identify signs of pipe failure (leaks) along waterward and landward slopes. Recommend removing vegetation along pipe alignment to conduct proper inspection of structure and appurtenances. Pipe completely blocked by soil on LS toe due to animal activity. Slide gate blocked open.
FIELD_STRUCT_DESC: 48-inch CM pipe through the levee, 13.1 feet below the crown. Walkway to slidegate on LS toe at concrete headwall. Flap gate at concrete headwall on the WS toe. Brass cap No. 90 BM on headwall on the landward side. (USACE-1967). Pipe crosses levee at an angle to levee alignment. This entry matches the Drainage or Irrigation Structure referenced in O&M manual (HLM 6.13).
FS Date: 4/8/2014

Slidegate at LS toe.

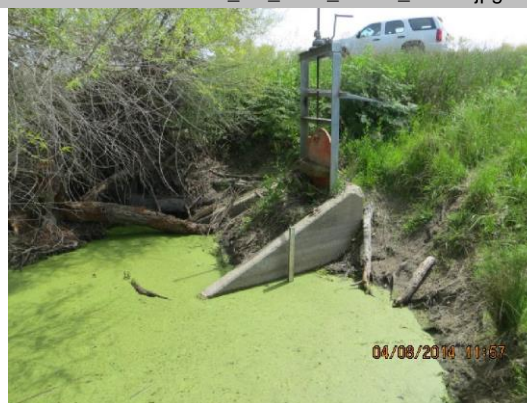
Photo 2 of 2 : UCIP_SP_2016_39152_60744.jpg

Pipe, concrete headwall, slidegate, and metal walkway on LS toe.

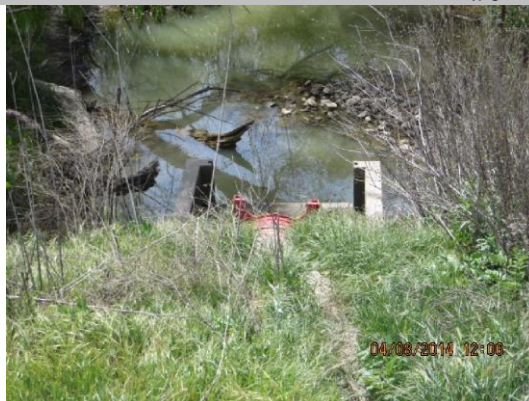
Photo 1 of 2 : UCIP_SP_2016_39154_60762.jpg

FS_ID:39154
DS_ID:19613
EP_NO: N/A
Repair Type: Non-Urgent
Crossing Status: Found
UCIP Comments: Dense vegetation limits the inspector's visibility to identify signs of pipe failure (leaks) along the slope. Recommend removing vegetation along pipe alignment to conduct proper inspection of structure and appurtenances.
FIELD_STRUCT_DESC: 24-inch CM stormdrain pipe through the levee, 9.5 feet below the crown. Flap gate on the waterward end. Slide gate on the landward end next to 48-inch concrete riser with walkway over its top. Brass cap No. 90 BM on headwall on the landward side. (USACE-1967). This entry matches the Drainage or Irrigation Structure referenced in O&M manual (HLM 6.40).
FS Date: 4/8/2014

Pipe, flapgate, and concrete headwall on WS toe.

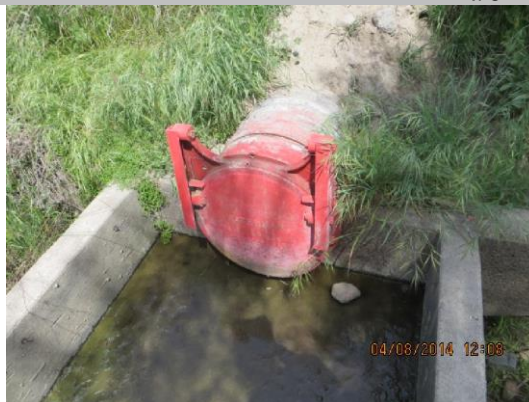
Photo 2 of 2 : UCIP_SP_2016_39154_60760.jpg

Pipe, flapgate, and concrete headwall on WS toe.

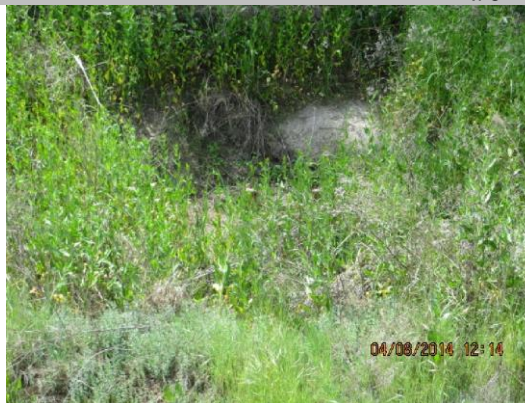
Photo 1 of 2 : UCIP_SP_2016_41134_60764.jpg

FS_ID:41134
DS_ID:19614
EP_NO: N/A
Repair Type: Urgent
Crossing Status: Found
UCIP Comments: Flapgate blocked by sedimentation at WS toe. Dense vegetation limits the inspector's visibility to identify signs of pipe failure (leaks) along the slope. Recommend removing vegetation along pipe alignment to conduct proper inspection of structure and appurtenances. Also recommend clearing vegetation from both waterward and landward toe.
FIELD_STRUCT_DESC: 24-inch CM stormdrain pipe through the levee, 9.8 feet below the crown. Wooden fence around 4'X4' drop inlet on LS toe. Flap gate on the waterward end. Brass cap No. 90 BM on headwall on the landward side. (USACE-1967). This entry matches the Drainage or Irrigation Structure referenced in O&M manual (HLM 6.64).
FS Date: 4/8/2014

Pipe and flapgate visible on WS toe.

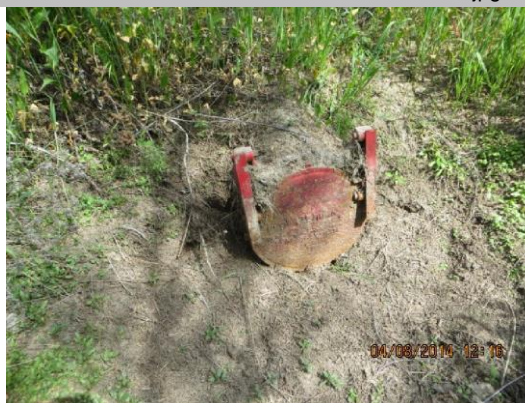
Photo 2 of 2 : UCIP_SP_2016_41134_60766.jpg

Pipe and flapgate visible at WS toe. Flapgate blocked by sedimentation on WS toe.

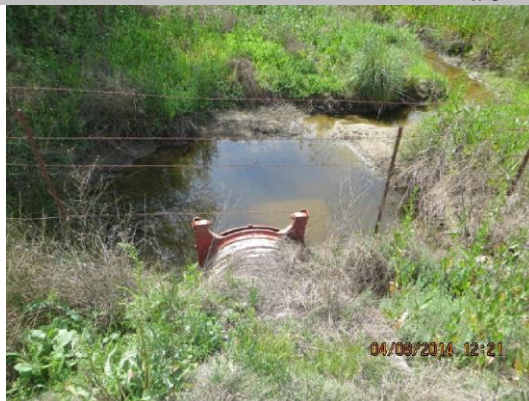
Photo 1 of 2 : UCIP_SP_2016_42850_60768.jpg

FS_ID:42850
DS_ID:19615
EP_NO: N/A
Repair Type: Urgent
Crossing Status: Found
UCIP Comments: Slide gate blocked by debris at LS toe. Flapgate won't close because of debris. Dense vegetation limits the inspector's visibility to identify signs of pipe failure (leaks) along the slope. Recommend removing vegetation along pipe alignment to conduct proper inspection of structure and appurtenances.
FIELD_STRUCT_DESC: 36-inch CM stormdrain pipe through the levee, 10.3 feet below the crown. Slidegate on LS toe and a Flap gate on the waterward end. Brass cap No. 90 BM on headwall on the landward side. (USACE-1967). This entry matches the Drainage or Irrigation Structure referenced in O&M manual (HLM 6.90).
FS Date: 4/8/2014

Pipe, headwall, and flapgate on WS toe.

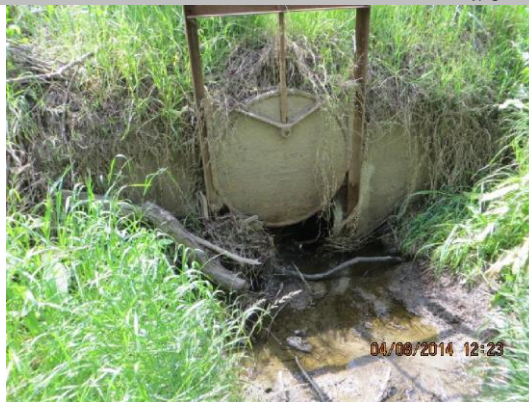
Photo 2 of 2 : UCIP_SP_2016_42850_60767.jpg

Pipe, concrete headwall, and slidegate on LS toe. Debris blocking closure of slidegate.

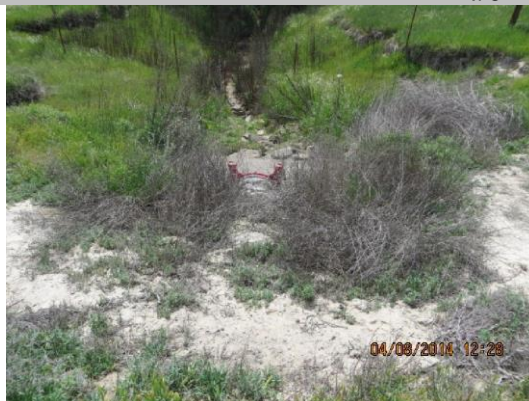
Photo 1 of 2 : UCIP_SP_2016_42851_60770.jpg

Comment Code					
Inspector Comment					
FS_ID:42851 DS_ID:19616 EP_NO: N/A Repair Type: Non-Urgent Crossing Status: Found UCIP Comments: Pipe failing and corroded through at LS toe. Need to contact owner to determine status of crossing. Also dense vegetation limits the inspector's visibility to identify signs of pipe failure (leaks) along the landward slope. Recommend removing vegetation along pipe alignment to conduct proper inspection of structure. FIELD_STRUCT_DESC: 24-inch CM stormdrain pipe through the levee, 5.1 feet below the crown. Flap gate on the waterward end. Brass cap No. 90 BM on headwall on the landward side. (USACE-1967). This entry matches the Drainage or Irrigation Structure referenced in O&M manual (HLM 7.21). FS Date: 4/8/2014

Pipe, concrete headwall, and flapgate on WS toe.

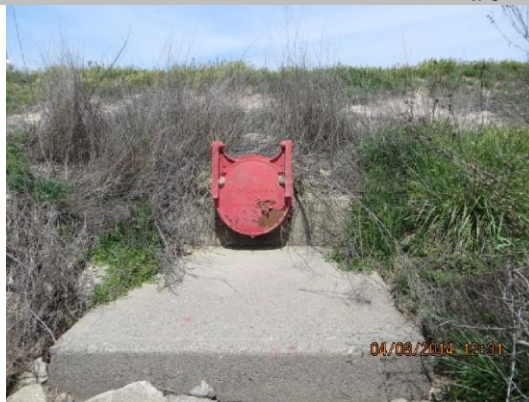
Photo 2 of 2 : UCIP_SP_2016_42851_60772.jpg

Flapgate and concrete headwall on WS toe.

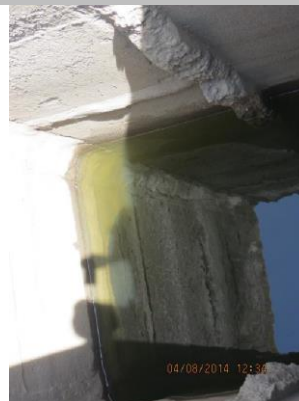
Photo 1 of 2 : UCIP_SP_2016_39160_60776.jpg

Comment Code					
Inspector Comment					
FS_ID:39160 DS_ID:19617 EP_NO: 4425 Repair Type: Non-Urgent Crossing Status: Found UCIP Comments: Recommend contacting owner to determine status of crossing. No pump was found on waterwaard side (riverbank). If crossing is no longer used need to coordinate with CVFPB for proper abandonment. FIELD_STRUCT_DESC: 24-inch steel irrigation pipe through the levee, 13.6 feet below the crown. Pipe encased in 6-inches of concrete through levee. 5'X7' Concrete distribution box on the waterward side. 20-inch concrete standpipe at LS toe. Pump on the riverbank, accessible by walkway platform (Pump not found). Concrete cutoff walls around pipe in line with levee shoulders. Pipe extends to 36-inch concrete pipes on both sides of levee. (Permit No. 4425-1965) FS Date: 4/8/2014

Pipe visible under water in concrete box riser on WS toe.

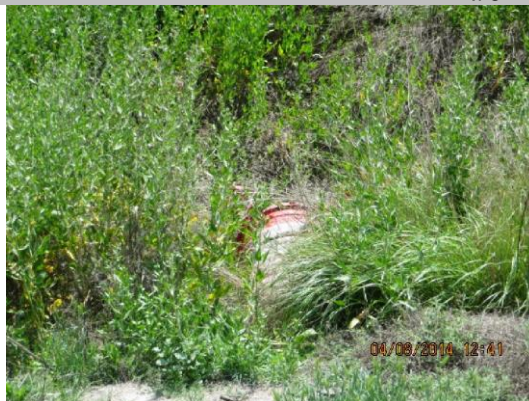
Photo 1 of 2 : UCIP_SP_2016_39161_60778.jpg

Comment Code					
Inspector Comment					
FS_ID:39161 DS_ID:19618 EP_NO: N/A Repair Type: Non-Urgent Crossing Status: Found UCIP Comments: Dense vegetation limits the inspector's visibility to identify signs of pipe failure (leaks) along the slope. Recommend removing vegetation along pipe alignment to conduct proper inspection of structure and appurtenances. FIELD_STRUCT_DESC: 24-inch CM stormdrain pipe through the levee, 8.0 feet below the crown. Flap gate on the waterward end. Brass cap No. 80 BM on headwall on the landward side. (USACE-1967). This entry matches the Drainage or Irrigation Structure referenced in O&M manual (HLM 7.46). FS Date: 4/8/2014

Pipe and flapgate visible on WS toe.

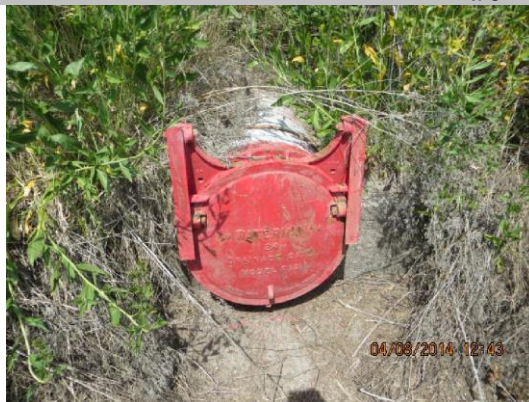
Photo 2 of 2 : UCIP_SP_2016_39161_60780.jpg

Pipe and flapgate visible on WS toe.

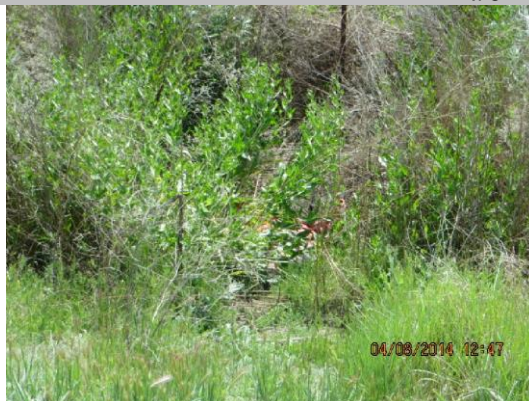
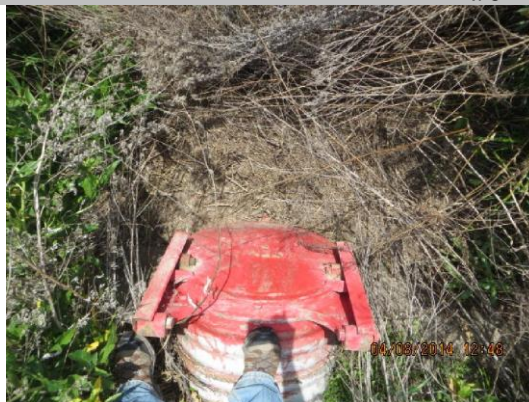
LM Start	7.65	Rating **	M	Issue No.	1191
LM End	7.65	Issue Type +	En	Location *	LS
Category	Supplemental			GPS Latitude/Longitude	
				Start	End
Item	DWR UCIP Field Study			37.299211 °	37.299211 °
				-120.874415 °	-120.874415 °
DWR ID					
Comment Code					
Inspector Comment					
FS_ID:39243 DS_ID:19619 EP_NO: N/A Repair Type: Non-Urgent Crossing Status: Found UCIP Comments: Dense vegetation limits the inspector's visibility to identify signs of pipe failure (leaks) along the slope. Recommend removing vegetation along pipe alignment to conduct proper inspection of structure. FIELD_STRUCT_DESC: 24-inch CM pipe through the levee, 10.0 feet below the crown. Flap gate on the waterward end. Brass cap No. 80 BM on headwall on the landward side. (USACE-1967). This entry matches the Drainage or Irrigation Structure referenced in O&M manual (HLM 7.69). FS Date: 4/8/2014

Flapgate and headwall at WS toe. Heavy vegetation on slopes.

Flapgate and headwall at WS toe.

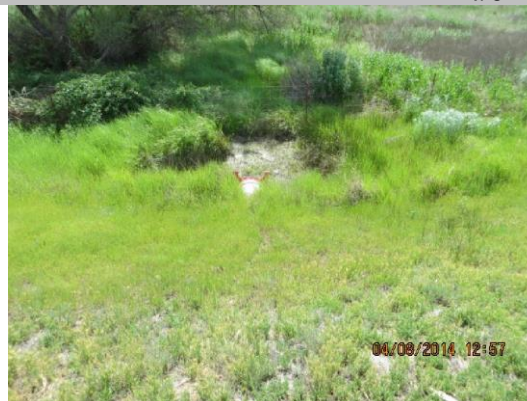
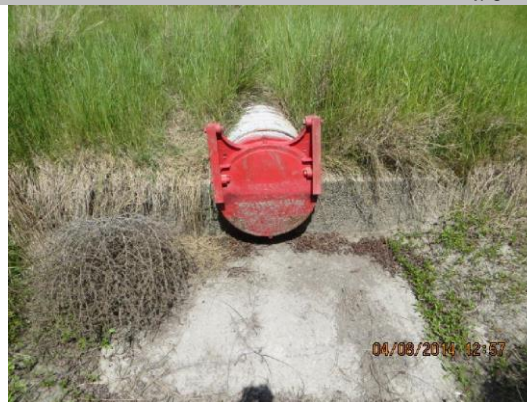
Comment Code					
Inspector Comment					
FS_ID:39244					
DS_ID:19620					
EP_NO: N/A					
Repair Type: Non-Urgent					
Crossing Status: Found					
UCIP Comments: Dense vegetation limits the inspector's visibility to identify signs of pipe failure (leaks) along the slope. Recommend removing vegetation along pipe alignment to conduct proper inspection of structure.					
FIELD_STRUCT_DESC: 24-inch CM stormdrain pipe through the levee, 8.0 feet below the crown. Flap gate on the waterward end. Brass cap No. 80 BM on headwall on the landward side. (USACE-1967). This entry matches the Drainage or Irrigation Structure referenced in O&M manual (HLM 8.07).					
FS Date: 4/9/2014

Pipe, Headwall, and flapgate at WS toe.
