**Flood Control Project Maintenance
Levee Inspections****LMA District Cover Sheet****Spring 2016 Levee Inspection Results****Lower San Joaquin Levee District**

Spring 2016 Levee Inspection Results

Lower San Joaquin Levee District

Waterway			Bank	Unit Miles
Unit No. 01 San Joaquin River			Right	22.52
	Spring (March - May)	Summer (June - August)	(September - November) Fall	Winter (December - February)
Unit Maintenance Rating (Fall Only)				
Date of Inspection	5/16/2016 - 5/19/2016			
DWR Inspector	Richard Willoughby			
Accompanied By

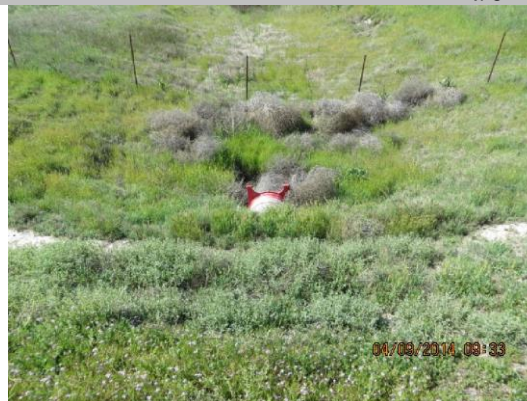
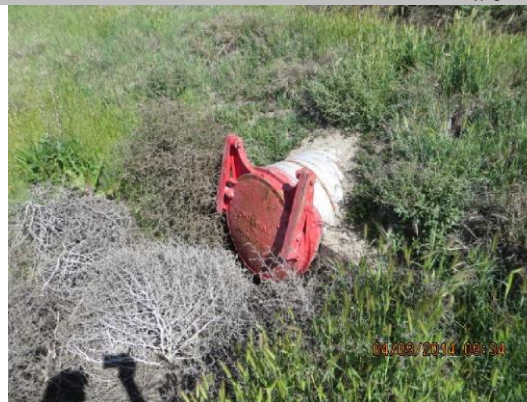
Comment Code						
Inspector Comment						
FS_ID:39245						
DS_ID:19621						
EP_NO: N/A						
Repair Type: Non-Urgent						
Crossing Status: Found						
UCIP Comments: Dense vegetation limits the inspector's visibility to						
identify signs of pipe failure (leaks) along the slope. Recommend						
removing vegetation along pipe alignment to conduct proper inspection						
of structure. Sediment buildup at landward toe.						
FIELD_STRUCT_DESC: 24-inch CM pipe through the levee, 9.5 feet						
below the crown. Flap gate on the waterward end. Brass cap No. 80 BM						
on headwall on the landward side. (USACE-1967). This entry matches						
the Drainage or Irrigation Structure referenced in O&M manual (HLM

Concrete headwall, pipe, and flapgate at WS toe.

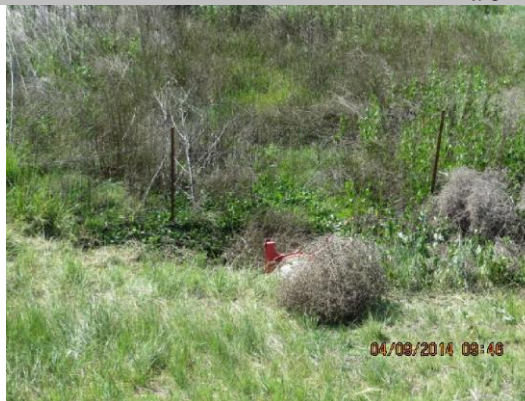
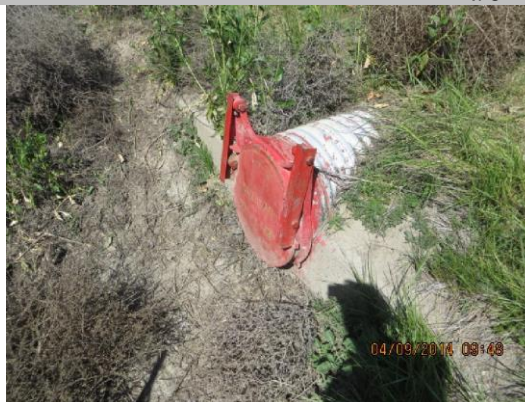
LM Start	8.89	Rating **	M	Issue No.	1194
LM End	8.89	Issue Type +	En	Location *	LS
Category	Supplemental			GPS Latitude/Longitude	
				Start	End
Item	DWR UCIP Field Study			37.297296 °	37.297296 °
				-120.852871 °	-120.852871 °
DWR ID					
Comment Code					
Inspector Comment					
FS_ID:39247 DS_ID:19623 EP_NO: N/A Repair Type: Non-Urgent Crossing Status: Found UCIP Comments: Dense vegetation limits the inspector's visibility to identify signs of pipe failure (leaks) along the slope. Recommend removing vegetation along pipe alignment to conduct proper inspection of structure. FIELD_STRUCT_DESC: 24-inch CM stormdrain pipe through the levee, 9.1 feet below the crown. Flap gate on the waterward end. Brass cap No. 80 BM on headwall on the landward side. (USACE-1967). This entry matches the Drainage or Irrigation Structure referenced in O&M manual (HLM 8.93). FS Date: 4/9/2014

Pipe, flapgate, and headwall on WS toe.

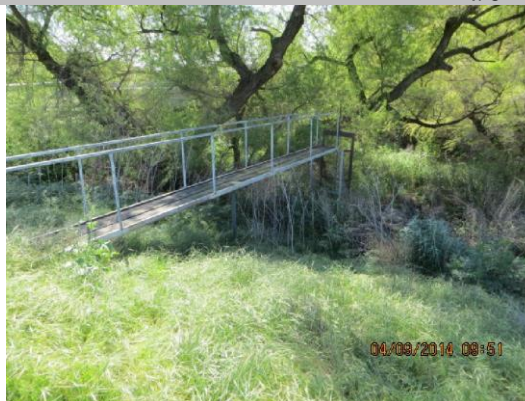
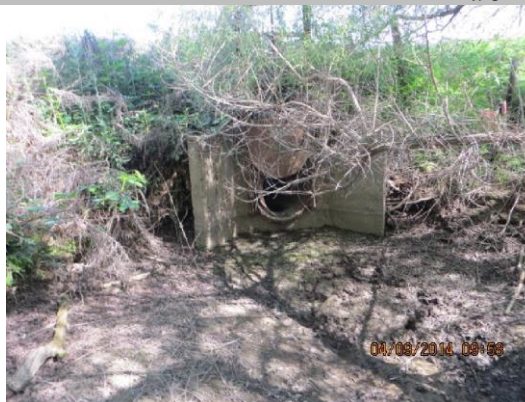
FS_ID:39248
DS_ID:19624
EP_NO: 12156
Repair Type: Urgent
Crossing Status: Found
UCIP Comments: Slide gate rusted through and open on WS toe. Inlet appears to be obscured or covered in soil at LS toe. Also dense vegetation on waterward and landward sides. Need to contact owner to contact CVFPB to address issue.
FIELD_STRUCT_DESC: 30-inch concrete drainpipe through the levee, 7.3 feet below the crown. Encasing 26-inch steel pipe through entire section, annular gap grouted. Concrete wingwalls on each side of pipe. Slide gate on discharge end with elevated walkway access. Two concrete cutoff walls in center of levee. Concrete headwall (6-inch thick) on discharge end of pipe. (Permit No. 12156-1978)
FS Date: 4/9/2014

Metal walkway to slidegate operator on WS toe.

Slidegate and headwall at WS toe.

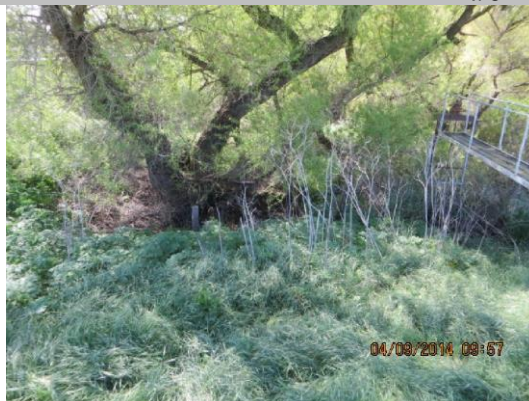
Comment Code					
Inspector Comment					
FS_ID:39249 DS_ID:19625 EP_NO: N/A Repair Type: Non-Urgent Crossing Status: Found UCIP Comments: Dense vegetation limits the inspector's visibility to identify signs of pipe failure (leaks) along the slope. Recommend removing vegetation along pipe alignment to conduct proper inspection of structure. Some sediment buildup in pipe. FIELD_STRUCT_DESC: 36-inch CM stormdrain pipe through the levee, 10.0 feet below the crown. Flap gate on the waterward end. Brass cap No. 80 BM on headwall on the landward side. (USACE-1967). This entry matches the Drainage or Irrigation Structure referenced in O&M manual (HLM 9.00). FS Date: 4/9/2014

Pipe and flapgate visible on WS toe.

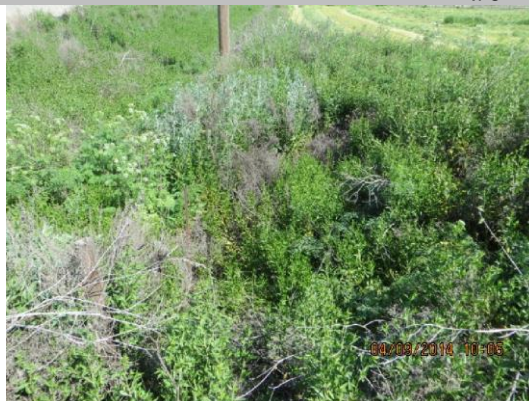
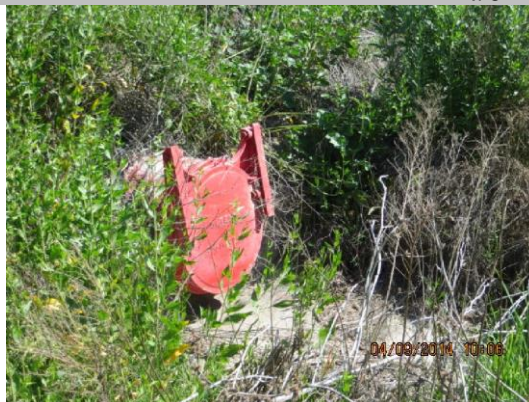
Comment Code					
Inspector Comment					
FS_ID:39250					
DS_ID:19626					
EP_NO: N/A					
Repair Type: Non-Urgent					
Crossing Status: Found					
UCIP Comments: Dense vegetation limits the inspector's visibility to identify signs of pipe failure (leaks) along the slope. Recommend removing vegetation along pipe alignment to conduct proper inspection of structure.					
FIELD_STRUCT_DESC: 24-inch CM stormdrain pipe through the levee, 10.0 feet below the crown. Flap gate on the waterward end. Brass cap No. 80 BM on headwall on the landward side. (USACE-1967). This entry matches the Drainage or Irrigation Structure referenced in O&M manual (HLM 9.03).					
FS Date: 4/9/2014

Heavy vegetation on LS toe.

Pipe, concrete headwall, and flapgate at WS toe.

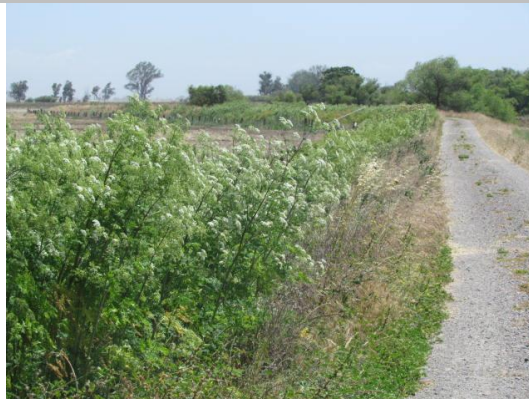
Photo 1 of 1 : SP_2016_NA0010_118_12_20160523_00238.jpg

LM Start	8.99	Rating **	U	Issue No.	12
LM End	9.72	Issue Type +	Ma	Location *	LS
Category	Earthen Levee			GPS Latitude/Longitude	
				Start	End
Item	Vegetation			37.297508 °	37.293801 °
				-120.851103 °	-120.839759 °
DWR ID	DWR_NA0010_01_f_2015_12				
Comment Code					
V2 : Remove the wild growth other than native grasses from the levee slopes.					
Inspector Comment

Looking southeast at dense veg on landward slope.

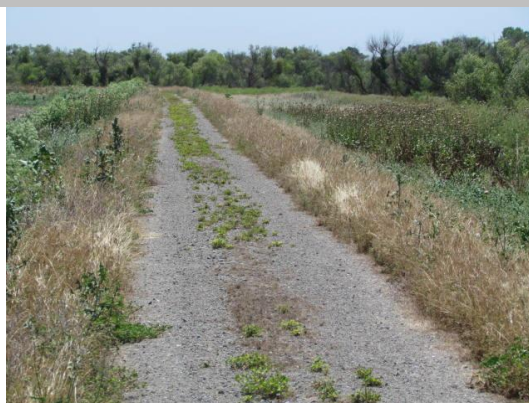
Photo 1 of 1 : SP_2016_NA0010_118_94_20160523_00239.jpg

LM Start	9.03	Rating **	U	Issue No.	94
LM End	9.72	Issue Type +	Ma	Location *	WS
Category	Earthen Levee			GPS Latitude/Longitude	
				Start	End
Item	Vegetation			37.297380 °	37.293801 °
				-120.850388 °	-120.839759 °
DWR ID	DWR_NA0010_01_f_2015_94				
Comment Code					
V2 : Remove the wild growth other than native grasses from the levee slopes.					
Inspector Comment

Looking southwest at dense veg on waterward slope.

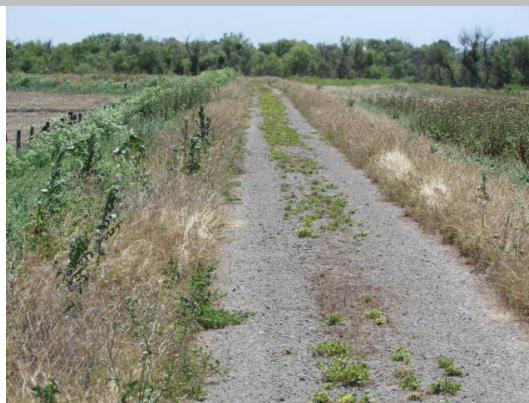
Photo 1 of 1 : SP_2016_NA0010_118_117_20160523_00240.jpg

LM Start	9.16	Rating **	M	Issue No.	117
LM End	9.78	Issue Type +	Ma	Location *	CR
Category	Earthen Levee			GPS Latitude/Longitude	
				Start	End
Item	Crown Surface / Depressions / Rutting			37.296145 °	37.293077 °
				-120.848588 °	-120.839170 °
DWR ID	DWR_NA0010_01_s_2012_117				
Comment Code					
C1 : Add appropriate material and re-grade the levee to bring the crown above the design elevation.					
Inspector Comment					
Control vegetation on levee crown.

Looking south at veg on levee crown.

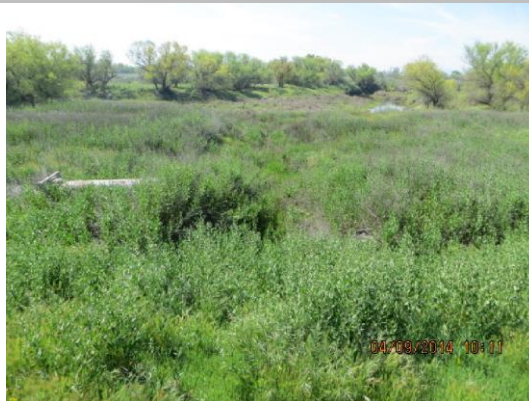
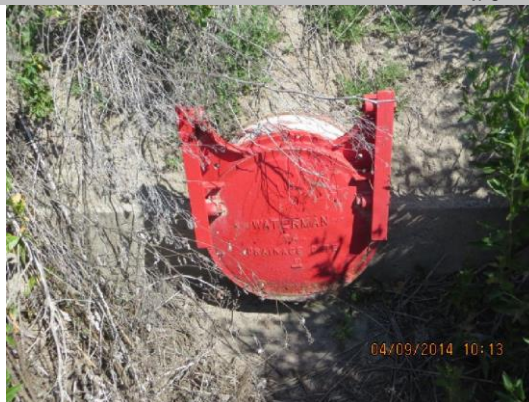
Comment Code						
Inspector Comment						
FS_ID:39251 DS_ID:19627 EP_NO: N/A Repair Type: Non-Urgent Crossing Status: Found UCIP Comments: Dense vegetation limits the inspector's visibility to identify signs of pipe failure (leaks) along the slope. Recommend removing vegetation along pipe alignment to conduct proper inspection of structure. FIELD_STRUCT_DESC: 24-inch CM stormdrain pipe through the levee, 8.6 feet below the crown. Concrete drop-inlet installed at LS toe. Flap gate on the waterward end. Brass cap No. 80 BM on headwall on the landward side. (USACE-1967). This entry matches the Drainage or Irrigation Structure referenced in O&M manual (HLM 9.37). FS Date: 4/9/2014

Pipe and flapgate on WS toe.

Headwall, Pipe, and flapgate on WS toe.

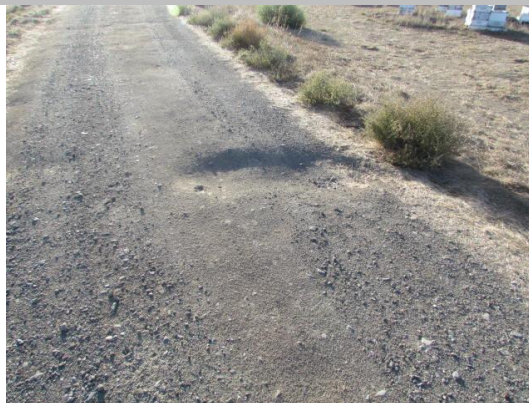
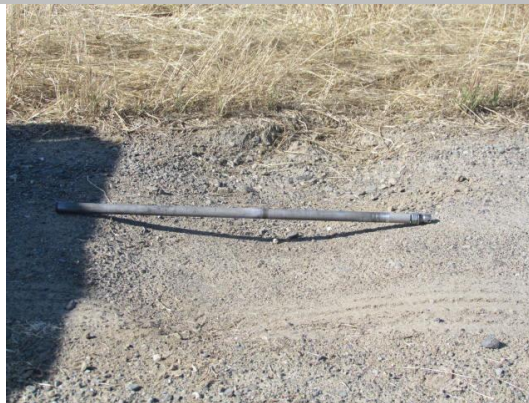
LM Start	9.57	Rating **	M	Issue No.	14
LM End	9.57	Issue Type +	Ma	Location *	CR
Category	Earthen Levee			GPS Latitude/Longitude	
				Start	End
Item	Crown Surface / Depressions / Rutting			37.295517 °	37.295517 °
				-120.841452 °	-120.841452 °
DWR ID	DWR_NA0010_01_s _ 2015_14				
Comment Code					
C2 : Repair depressions or ruts in the crown or slope.					
Inspector Comment					
Depression greater than 3" deep by 18" wide by 18" long on levee crown

Looking at depression on levee crown. (Fall 2015)

Looking west at depression greater than three inches on levee crown.

Looking west at depression on levee crown.

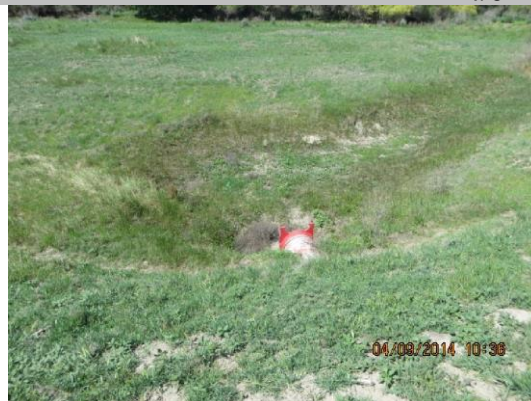
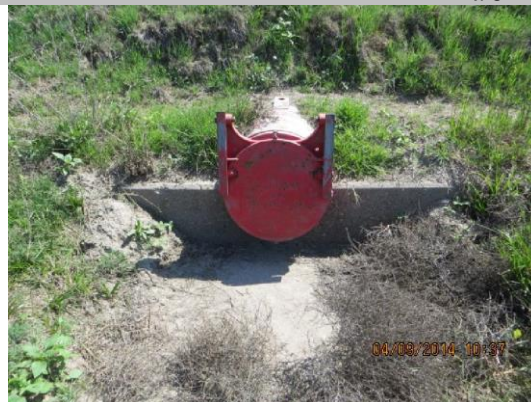
FS_ID:39253
DS_ID:19629
EP_NO: N/A
Repair Type: Non-Urgent
Crossing Status: Found
UCIP Comments: Dense vegetation blocks waterward and landward toes Recommend removing vegetation from both toes. Also sediment buildup in pipe visible from landward side.
FIELD_STRUCT_DESC: 24-inch CM stormdrain pipe through the levee, 9.0 feet below the crown. Flap gate on the waterward end. Brass cap No. 69 BM on headwall on the landward side. (USACE-1967). This entry matches the Drainage or Irrigation Structure referenced in O&M manual (HLM 10.23).
FS Date: 4/9/2014

Pipe, headwall, and flapgate on WS toe.

Pipe, headwall, and flapgate at WS toe.

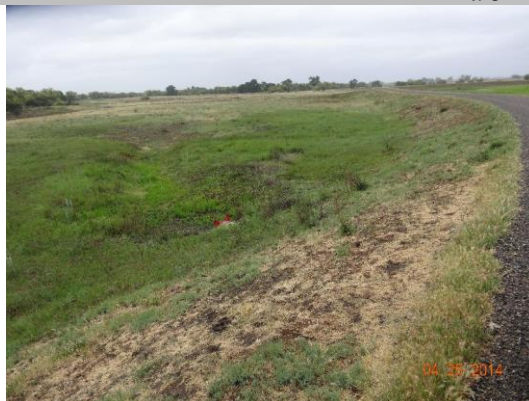
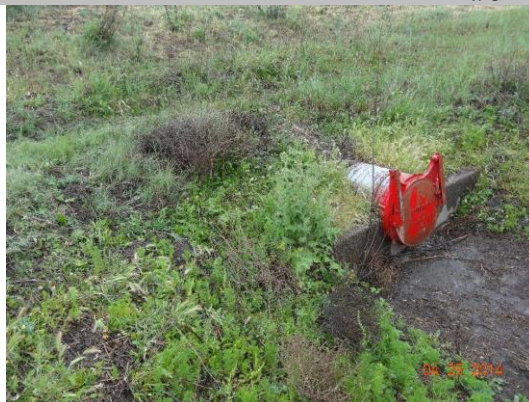
LM Start	11.49	Rating **	M	Issue No.	1248
LM End	11.49	Issue Type +	En	Location *	CR
Category	Supplemental			GPS Latitude/Longitude	
				Start	End
Item	DWR UCIP Field Study			37.273787 °	37.273787 °
				-120.825519 °	-120.825519 °
DWR ID					
Comment Code					
Inspector Comment					
FS_ID:36103 DS_ID:19634 EP_NO: N/A Repair Type: Non-Urgent Crossing Status: Found UCIP Comments: Need to contact owner--landward side has been buried. It appears that soil was removed from levee toe, immediately upstream, and used to pile soil at landward side at crossing. FIELD_STRUCT_DESC: 24-inch CM pipe through the levee, 10.0 feet below the crown. Flap gate on the waterward end. Brass cap No. 62 BM on headwall on the landward side. (USACE-1967). This entry matches the Drainage or Irrigation Structure referenced in O&M manual (HLM 11.48). FS Date: 4/25/2014

View of waterward side.

View of concrete headwall and flap gate visible on waterward side.

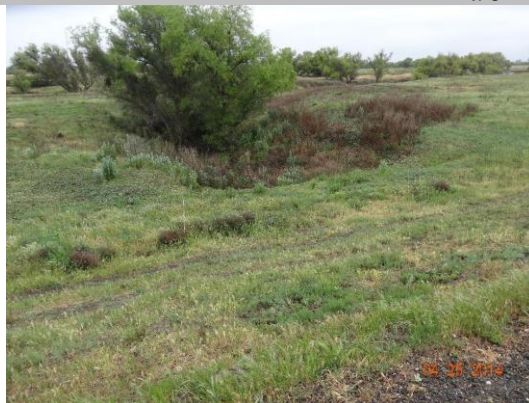
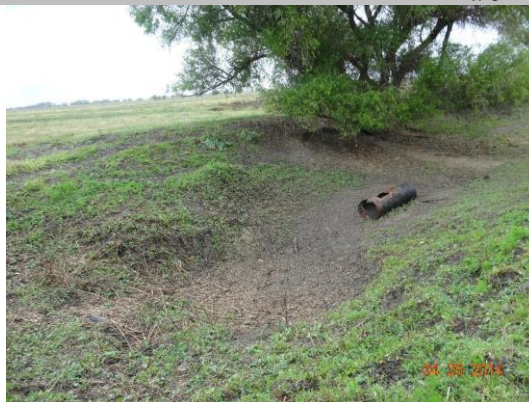
FS_ID:36105
DS_ID:19635
EP_NO: N/A
Repair Type: Non-Urgent
Crossing Status: Found
UCIP Comments: Crossing is non-functional --landward side is buried. Debris found on landward side (channel). Dense vegetation found on waterward slope. Recommend contacting owner to determine status of crossing. If crossing is no longer used need to coordinate with CVFPB for proper abandonment.
FIELD_STRUCT_DESC: 24-inch CM pipe through the levee, 17.0 feet below the crown. Flap gate on the waterward end. Brass cap No. 61 BM on headwall on the landward side. (USACE-1967). This entry matches the Drainage or Irrigation Structure referenced in O&M manual (HLM 11.76).
FS Date: 4/25/2014

View of waterward side.

Landward side of crossing buried--damage pipe section visible on landward side.

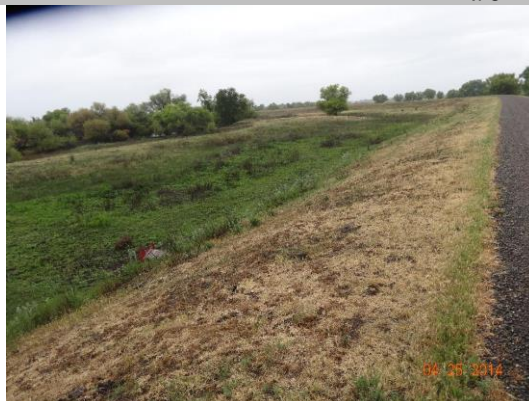
Comment Code					
Inspector Comment					
FS_ID:36106 DS_ID:19636 EP_NO: N/A Repair Type: Non-Urgent Crossing Status: Found UCIP Comments: Crossing is non-functional --landward side is buried. Dense vegetation found on waterward slope. Recommend contacting owner to determine status of crossing. If crossing is no longer used need to coordinate with CVFPB for proper abandonment. FIELD_STRUCT_DESC: 24-inch CM pipe through the levee, 12.4 feet below the crown. Flap gate on the waterward end. Brass cap No. 60 BM on headwall on the landward side. (USACE-1967). This entry matches the Drainage or Irrigation Structure referenced in O&M manual (HLM 12.11). FS Date: 4/25/2014

View of waterward side--flap gate visible on waterward toe.

Flap gate and concrete headwall visible on waterward side.

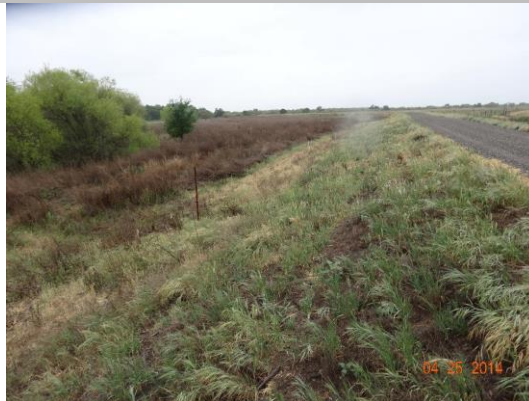
Photo 1 of 2 : UCIP_SP_2016_36146_65412.jpg

Comment Code					
Inspector Comment					
FS_ID:36146 DS_ID:19637 EP_NO: N/A Repair Type: Non-Urgent Crossing Status: Found UCIP Comments: Concrete headwall on landward side blocked by debris. Dense vegetation limits the inspector's visibility to identify signs of pipe failure (leaks) along the landward slope. Recommend removing vegetation along pipe alignment to conduct proper inspection of crossing. FIELD_STRUCT_DESC: 24-inch CM pipe through the levee, 9.5 feet below the crown. Flap gate on the waterward end. Brass cap No. 60 BM on headwall on the landward side. (USACE-1967). This entry matches the Drainage or Irrigation Structure referenced in O&M manual (HLM 12.94). FS Date: 4/25/2014

View of waterward side.

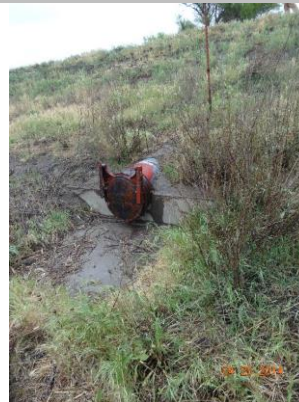
Photo 2 of 2 : UCIP_SP_2016_36146_65411.jpg

Flap gate and concrete headwall visible on waterward side.

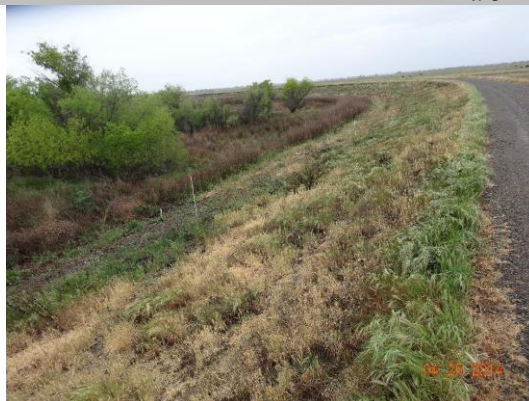
Photo 1 of 2 : UCIP_SP_2016_36109_65389.jpg

Comment Code					
Inspector Comment					
FS_ID:36109 DS_ID:19638 EP_NO: N/A Repair Type: Non-Urgent Crossing Status: Found UCIP Comments: Dense vegetation limits the inspector's visibility to identify signs of pipe failure (leaks) along the landward slope. Concrete headwall blocked by debris located on landward toe. Recommend clearing debris from landward slope and toe. FIELD_STRUCT_DESC: 24-inch CM pipe through the levee, 14.2 feet below the crown. Flap gate on the waterward end. Brass cap No. 60 BM on headwall on the landward side. (USACE-1967). This entry matches the Drainage or Irrigation Structure referenced in O&M manual (HLM 13.48). FS Date: 4/25/2014

View of waterward side.

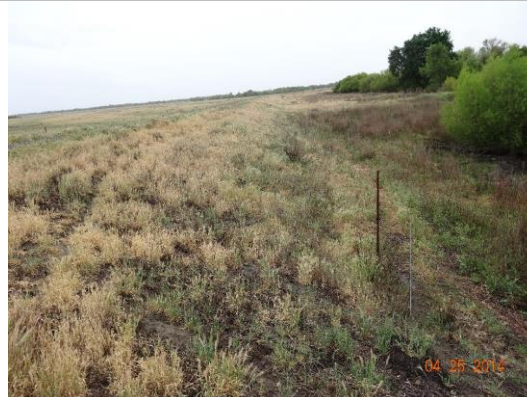
Photo 1 of 2 : UCIP_SP_2016_39256_65418.jpg

Comment Code					
Inspector Comment					
FS_ID:39256 DS_ID:19639 EP_NO: N/A Repair Type: Non-Urgent Crossing Status: Found UCIP Comments: No access to waterward toe due to fence. Unable to find the concrete headwall and flap gate on waterward side past fence. Also dense vegetation limits the inspector's visibility to identify signs of pipe failure (leaks) along the waterward slope. Recommend removing vegetation along pipe alignment to conduct proper inspection of structure. Also need access past fence on waterward side. FIELD_STRUCT_DESC: 24-inch CM pipe through the levee, 14.5 feet below the crown. Flap gate on the waterward end. Brass cap No. 60 BM on headwall on the landward side. (USACE-1967). This entry matches the Drainage or Irrigation Structure referenced in O&M manual (HLM 13.58). FS Date: 4/25/2014

View of waterward side.

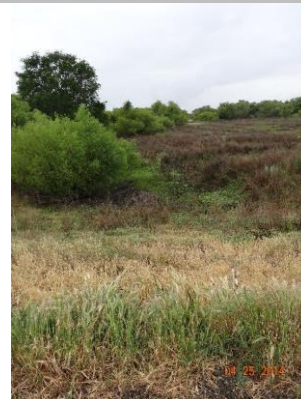
Photo 2 of 2 : UCIP_SP_2016_39256_65417.jpg

Dense vegetation on waterward side.

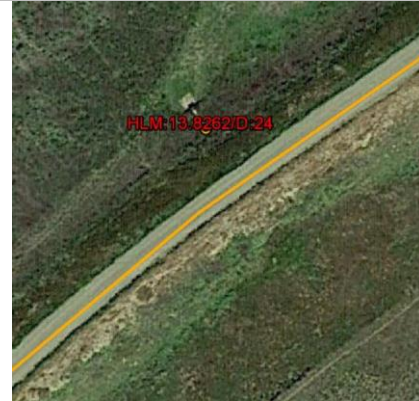
Photo 1 of 1 : UCIP_SP_2016_36544_66286.jpg

LM Start	13.82	Rating **	M	Issue No.	1246
LM End	13.82	Issue Type +	En	Location *	CR
Category	Supplemental			GPS Latitude/Longitude	
				Start	End
Item	DWR UCIP Field Study			37.247568 °	37.247568 °
				-120.817074 °	-120.817074 °
DWR ID					
Comment Code					
Inspector Comment					
FS_ID:36544 DS_ID:19640 EP_NO: N/A Repair Type: Non-Urgent Crossing Status: Indicator Found UCIP Comments: No photos available--missed crossing. Aerial photograph indicates crossing is present. Need to confirm if crossing is still present on waterward side. FIELD_STRUCT_DESC: 24-inch CM pipe through the levee, 11.0 feet below the crown. Flap gate on the waterward end. Brass cap No. 60 BM on headwall on the landward side. (USACE-1967). This entry matches the Drainage or Irrigation Structure referenced in O&M manual (HLM 13.81). FS Date: 4/25/2014

Indicators of crossing visible from aerial photograph.

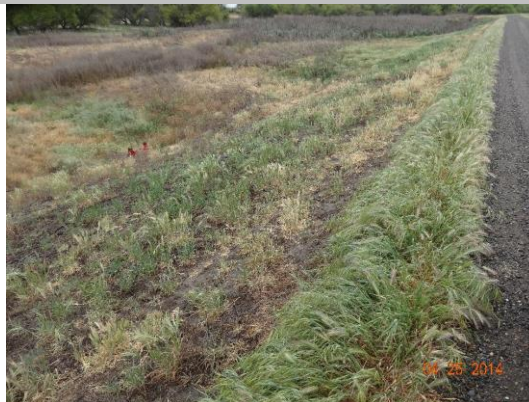
Photo 1 of 2 : UCIP_SP_2016_36167_65455.jpg

View of waterward side.

Comment Code					
Inspector Comment					
FS_ID:36167 DS_ID:19642 EP_NO: N/A Repair Type: Non-Urgent Crossing Status: Found UCIP Comments: Dense vegetation limits the inspector's visibility to identify signs of pipe failure (leaks) along the landward slope and toe. Recommend removing vegetation along pipe alignment to conduct proper inspection of structure. FIELD_STRUCT_DESC: 24-inch CM pipe through the levee, 9.7 feet below the crown. Flap gate on the waterward end. Brass cap No. 60 BM on headwall on the landward side. (USACE-1967). This entry matches the Drainage or Irrigation Structure referenced in O&M manual (HLM 14.65). FS Date: 4/25/2014

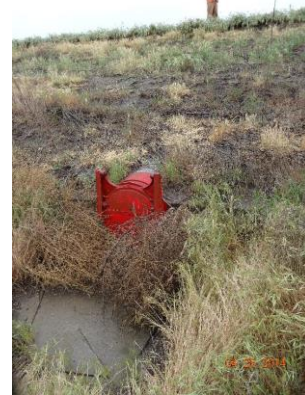
Photo 2 of 2 : UCIP_SP_2016_36167_65454.jpg

Flap gate, concrete headwall, and concrete apron located on waterward toe.

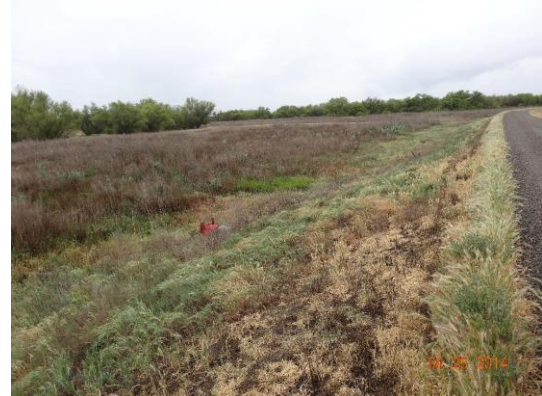
Photo 1 of 2 : UCIP_SP_2016_36168_65459.jpg

View of waterward side.

Item	DWR UCIP Field Study			37.231428 °		37.231428 °
				-120.805543 °		-120.805543 °
DWR ID						
Comment Code						
Inspector Comment						
FS_ID:36168						
DS_ID:19643						
EP_NO: N/A						
Repair Type: Non-Urgent						
Crossing Status: Found						
UCIP Comments: Dense vegetation limits the inspector's visibility to identify signs of pipe failure (leaks) along the landward slope.						
Recommend removing vegetation along pipe alignment to conduct proper inspection of structure.						
FIELD_STRUCT_DESC: 24-inch CM pipe through the levee, 9.2 feet below the crown. Flap gate on the waterward end. Brass cap No. 60 BM on headwall on the landward side. (USACE-1967). This entry matches the Drainage or Irrigation Structure referenced in O&M manual (HLM 15.29).						
FS Date: 4/25/2014

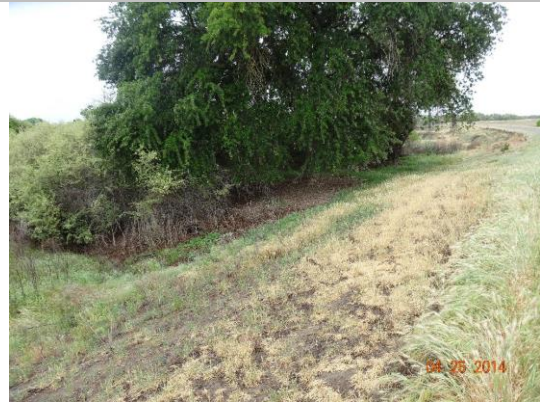
Photo 1 of 2 : UCIP_SP_2016_36171_65471.jpg

Comment Code					
Inspector Comment					
FS_ID:36171 DS_ID:19645 EP_NO: N/A Repair Type: Non-Urgent Crossing Status: Found UCIP Comments: Dense vegetation limits the inspector's visibility to identify signs of pipe failure (leaks) along the waterward and landward slope. Recommend removing vegetation along pipe alignment to conduct proper inspection of structure. FIELD_STRUCT_DESC: 24-inch CM pipe through the levee, 11.0 feet below the crown. Flap gate on the waterward end. Brass cap No. 60 BM on headwall on the landward side. (USACE-1967). This entry matches the Drainage or Irrigation Structure referenced in O&M manual (HLM 15.81). FS Date: 4/25/2014

View of waterward side.

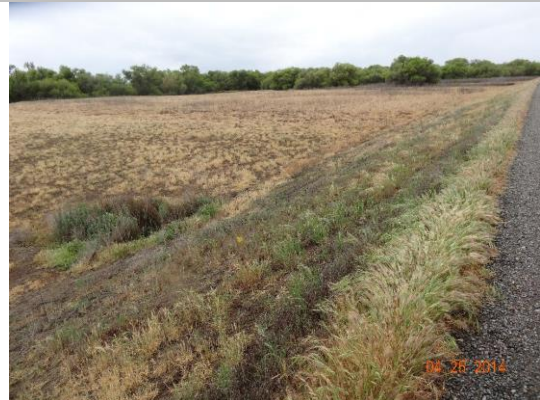
Photo 1 of 2 : UCIP_SP_2016_36172_65476.jpg

Comment Code					
Inspector Comment					
FS_ID:36172 DS_ID:19646 EP_NO: N/A Repair Type: Non-Urgent Crossing Status: Found UCIP Comments: Dense vegetation limits the inspector's visibility to identify signs of pipe failure (leaks) along the waterward and landward slopes. Recommend removing vegetation along pipe alignment to conduct proper inspection of structure and appurtenances. FIELD_STRUCT_DESC: 24-inch CM pipe through the levee, 11.3 feet below the crown. Flap gate on the waterward end. Brass cap No. 50 BM on headwall on the landward side. (USACE-1967). This entry matches the Drainage or Irrigation Structure referenced in O&M manual (HLM 16.09). FS Date: 4/25/2014

View of waterward side.

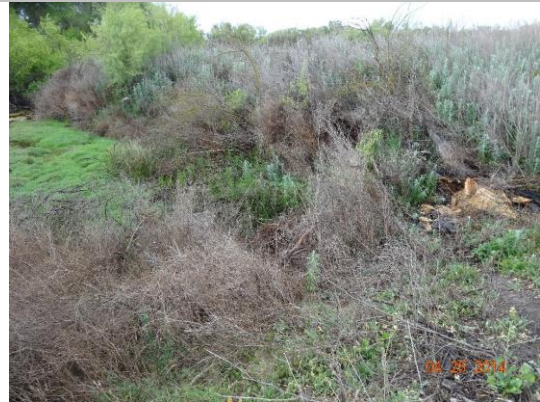
Photo 1 of 2 : UCIP_SP_2016_39257_65480.jpg

Comment Code					
Inspector Comment					
FS_ID:39257 DS_ID:19647 EP_NO: N/A Repair Type: Non-Urgent Crossing Status: Found UCIP Comments: Dense vegetation limits the inspector's visibility to identify signs of pipe failure (leaks) along the waterward and landward slopes. Recommend removing vegetation along pipe alignment to conduct proper inspection of structure. Unable to find pipe on landward side. FIELD_STRUCT_DESC: 24-inch CM pipe through the levee, 14.7 feet below the crown. Flap gate on the waterward end. Brass cap No. 50 BM on headwall on the landward side. (USACE-1967). This entry matches the Drainage or Irrigation Structure referenced in O&M manual (HLM 16.15). FS Date: 4/25/2014

View of waterward side.

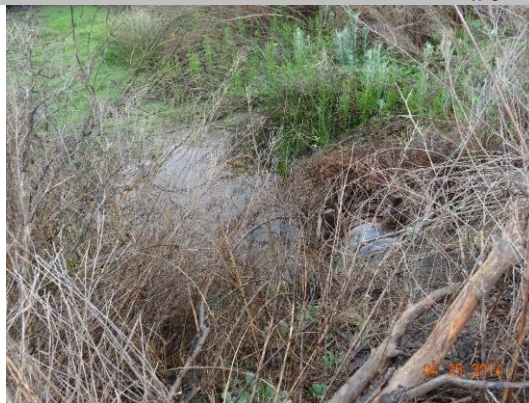
Photo 2 of 2 : UCIP_SP_2016_39257_65479.jpg

Item	DWR UCIP Field Study			37.224120	°	37.224120
				-120.794002	°	-120.794002
DWR ID						
Comment Code						
Inspector Comment						
FS_ID:39257 DS_ID:19647 EP_NO: N/A Repair Type: Non-Urgent Crossing Status: Found UCIP Comments: Dense vegetation limits the inspector's visibility to identify signs of pipe failure (leaks) along the waterward and landward slopes. Recommend removing vegetation along pipe alignment to conduct proper inspection of structure. Unable to find pipe on landward side. FIELD_STRUCT_DESC: 24-inch CM pipe through the levee, 14.7 feet below the crown. Flap gate on the waterward end. Brass cap No. 50 BM on headwall on the landward side. (USACE-1967). This entry matches the Drainage or Irrigation Structure referenced in O&M manual (HLM 16.15). FS Date: 4/25/2014

Crossing visible on waterward side under dense vegetation.

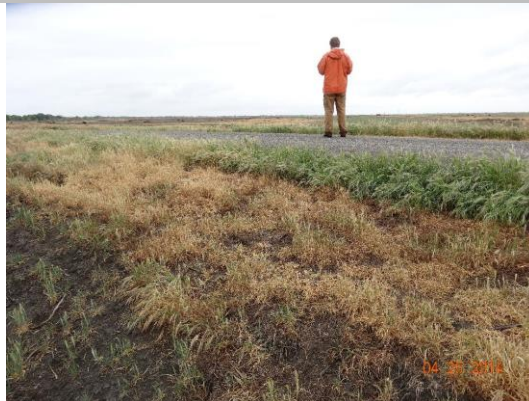
Photo 1 of 2 : UCIP_SP_2016_39258_66288.jpg

Comment Code					
Inspector Comment					
FS_ID:39258 DS_ID:19648 EP_NO: N/A Repair Type: Non-Urgent Crossing Status: Found UCIP Comments: Dense vegetation limits the inspector's visibility to identify signs of pipe failure (leaks) along the waterward and landward slopes. Recommend removing vegetation along pipe alignment to conduct proper inspection of structure. Unable to find pipe on landward side. FIELD_STRUCT_DESC: 24-inch CM pipe through the levee, 11.4 feet below the crown. Flap gate on the waterward end. Brass cap No. 50 BM on headwall on the landward side. (USACE-1967). This entry matches the Drainage or Irrigation Structure referenced in O&M manual (HLM 16.72). FS Date: 4/25/2014

View of levee crown at crossing.

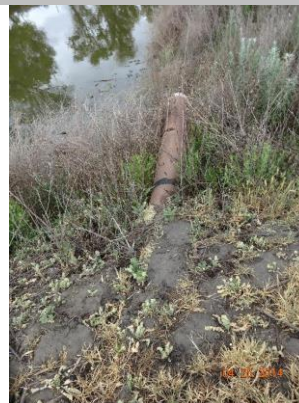
Photo 1 of 2 : UCIP_SP_2016_39360_71487.jpg

LM Start	16.72	Rating **	M	Issue No.	1235
LM End	16.72	Issue Type +	En	Location *	CR
Category	Supplemental			GPS Latitude/Longitude	
				Start	End
Item	DWR UCIP Field Study			37.224223 °	37.224223 °
				-120.783806 °	-120.783806 °
DWR ID					
Comment Code					
Inspector Comment					
FS_ID:39360 DS_ID:24870 EP_NO: N/A Repair Type: Non-Urgent Crossing Status: Found UCIP Comments: Need to contact owner to determine status and reason for crossing. FIELD_STRUCT_DESC: 12-inch steel pipe through the levee at an unknown depth. Concrete standpipe visible on landward side. FS Date: 4/25/2014

View of pipe located on waterward side.

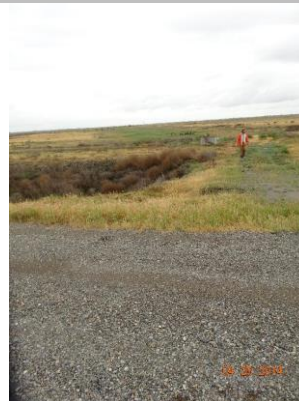
Photo 2 of 2 : UCIP_SP_2016_39360_71486.jpg

View of landward side.

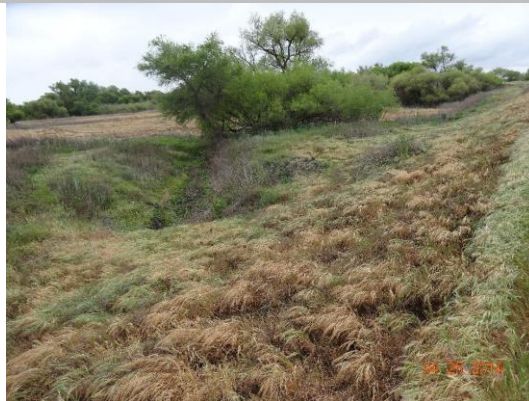
Photo 1 of 2 : UCIP_SP_2016_39259_65518.jpg

FS_ID:39259
DS_ID:19577
EP_NO: N/A
Repair Type: Non-Urgent
Crossing Status: Found
UCIP Comments: Dense vegetation limits the inspector's visibility to identify signs of pipe failure (leaks) along the waterward and landward slopes. Concrete headwall is buried by dense vegetation. Recommend removing vegetation along pipe alignment to conduct proper inspection of structure.
FIELD_STRUCT_DESC: 24-inch CM pipe through the levee, 11.5 feet below the crown. Flap gate on the waterward end. Brass cap No. 50 BM on headwall on the landward side. (USACE-1967). This entry matches the Drainage or Irrigation Structure referenced in O&M manual (HLM 17.01).
FS Date: 4/25/2014

View of waterward side.

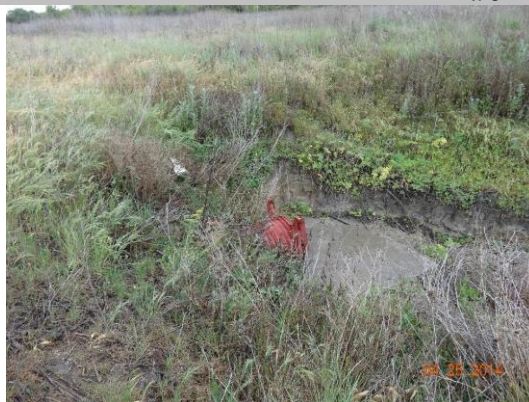
Photo 2 of 2 : UCIP_SP_2016_39259_65519.jpg

Flap gate visible on waterward side.

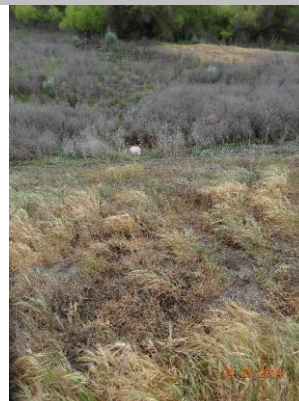
Photo 1 of 2 : UCIP_SP_2016_39260_65525.jpg

Comment Code					
Inspector Comment					
FS_ID:39260 DS_ID:19578 EP_NO: N/A Repair Type: Non-Urgent Crossing Status: Found UCIP Comments: Dense vegetation limits the inspector's visibility to identify signs of pipe failure (leaks) along the waterward and landward slopes. Recommend removing vegetation along pipe alignment to conduct proper inspection of structure. Sediment buildup inside pipe visible from landward side. Recommend clearing pipe. FIELD_STRUCT_DESC: 24-inch CM pipe through the levee, 11.5 feet below the crown. Flap gate on the waterward end. Brass cap No. 50 BM on headwall on the landward side. (USACE-1967). This entry matches the Drainage or Irrigation Structure referenced in O&M manual (HLM 17.19). FS Date: 4/25/2014

View of waterward side.

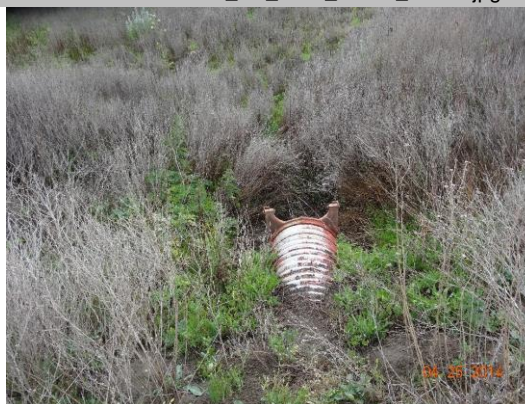
Photo 2 of 2 : UCIP_SP_2016_39260_65521.jpg

Pipe visible on waterward side.

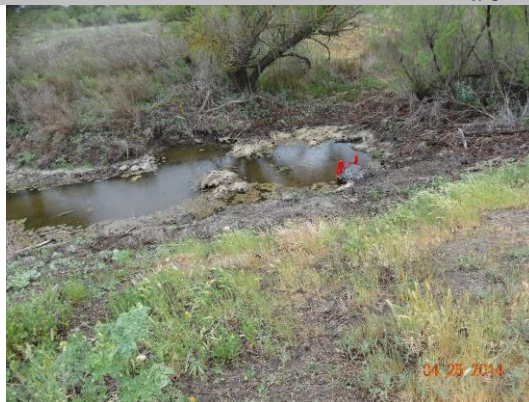
Photo 2 of 2 : UCIP_SP_2016_36203_65552.jpg

Comment Code					
Inspector Comment					
FS_ID:36203 DS_ID:19579 EP_NO: N/A Repair Type: Non-Urgent Crossing Status: Found UCIP Comments: Dense vegetation limits the inspector's visibility to identify signs of pipe failure (leaks) along the waterward and landward slope. Recommend removing vegetation along pipe alignment to conduct proper inspection of structure. FIELD_STRUCT_DESC: 24-inch CM pipe through the levee, 15.8 feet below the crown. Flap gate on the waterward end. Brass cap No. 50 BM on headwall on the landward side. (USACE-1967). This entry matches the Drainage or Irrigation Structure referenced in O&M manual (HLM 17.26). FS Date: 4/25/2014

Pipe visible on waterward side.

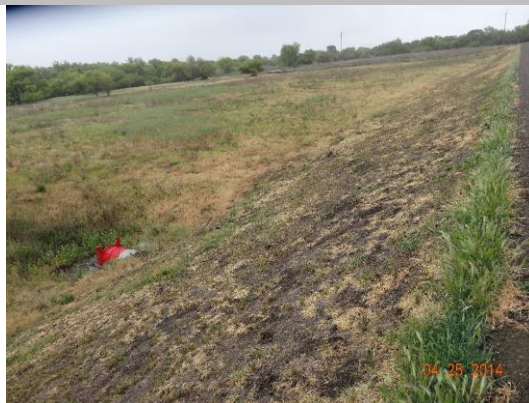
Photo 1 of 2 : UCIP_SP_2016_36204_65547.jpg

LM Start	17.52	Rating **	M	Issue No.	1244
LM End	17.52	Issue Type +	En	Location *	LS
Category	Supplemental			GPS Latitude/Longitude	
				Start	End
Item	DWR UCIP Field Study			37.215976 °	37.215976 °
				-120.777615 °	-120.777615 °
DWR ID					
Comment Code					
Inspector Comment					
FS_ID:36204 DS_ID:19580 EP_NO: N/A Repair Type: Non-Urgent Crossing Status: Found UCIP Comments: Dense vegetation limits the inspector's visibility to identify signs of pipe failure (leaks) along the landward slope. Recommend removing vegetation along pipe alignment to conduct proper inspection of structure. FIELD_STRUCT_DESC: 24-inch CM pipe through the levee, 9.5 feet below the crown. Flap gate on the waterward end. Brass cap No. 50 BM on headwall on the landward side. (USACE-1967). This entry matches the Drainage or Irrigation Structure referenced in O&M manual (HLM 17.53). FS Date: 4/25/2014

View of waterward side.

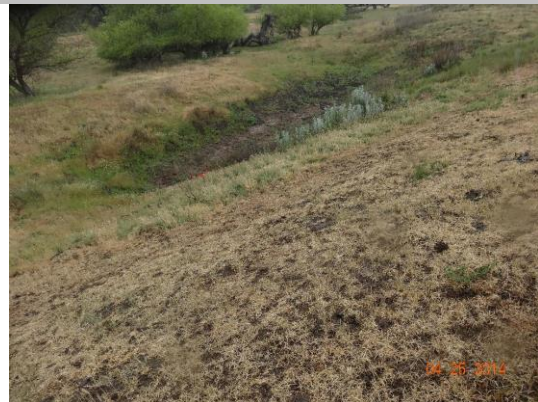
Photo 1 of 2 : UCIP_SP_2016_39261_65557.jpg

LM Start	18.18	Rating **	M	Issue No.	1211
LM End	18.18	Issue Type +	En	Location *	LS
Category	Supplemental			GPS Latitude/Longitude	
				Start	End
Item	DWR UCIP Field Study			37.210998 °	37.210998 °
				-120.768900 °	-120.768900 °
DWR ID					
Comment Code					
Inspector Comment					
FS_ID:39261 DS_ID:19581 EP_NO: N/A Repair Type: Non-Urgent Crossing Status: Found UCIP Comments: Need to contact owner. Recommend investigating integrity of pipe wall through levee heavy corrosion visible from landward side. FIELD_STRUCT_DESC: 24-inch CM pipe through the levee, 11.5 feet below the crown. Flap gate on the waterward end. Brass cap No. 50 BM on headwall on the landward side. (USACE-1967). This entry matches the Drainage or Irrigation Structure referenced in O&M manual (HLM 18.19). FS Date: 4/25/2014

View of waterward side.

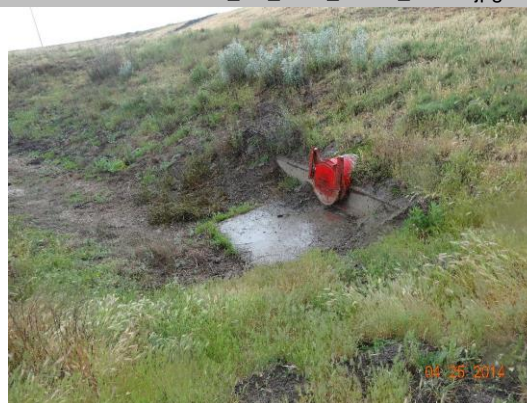
Photo 2 of 2 : UCIP_SP_2016_39261_65556.jpg

LM Start	18.18	Rating **	M	Issue No.	1211 (cont)	
LM End	18.18	Issue Type +	En	Location *	LS	
Category	Supplemental			GPS Latitude/Longitude		
				Start		End
Item	DWR UCIP Field Study			37.210998 °		37.210998 °
				-120.768900 °		-120.768900 °
DWR ID						
Comment Code						
Inspector Comment						
FS_ID:39261 DS_ID:19581 EP_NO: N/A Repair Type: Non-Urgent Crossing Status: Found UCIP Comments: Need to contact owner. Recommend investigating integrity of pipe wall through levee heavy corrosion visible from landward side. FIELD_STRUCT_DESC: 24-inch CM pipe through the levee, 11.5 feet below the crown. Flap gate on the waterward end. Brass cap No. 50 BM on headwall on the landward side. (USACE-1967). This entry matches the Drainage or Irrigation Structure referenced in O&M manual (HLM 18.19). FS Date: 4/25/2014

Flap gate visible on waterward side.

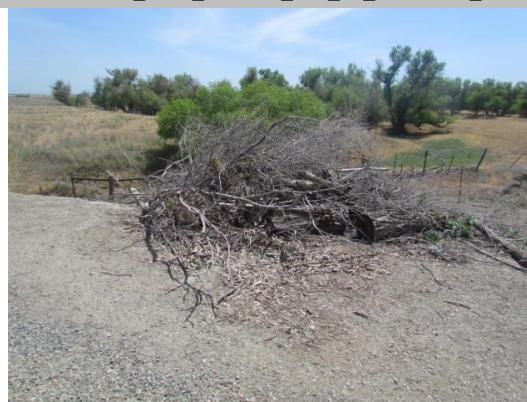
Photo 1 of 1 : SP_2016_NA0010_118_27_20160512_00017.jpg

LM Start	18.77	Rating **	M	Issue No.	27
LM End	18.77	Issue Type +	En	Location *	WS
Category	Earthen Levee			GPS Latitude/Longitude	
				Start	End
Item	Encroachments			37.205080 °	37.205080 °
				-120.762655 °	-120.762655 °
DWR ID	DWR_NA0010_01_s_2014_27				
Comment Code					
PR : Prunings					
Inspector Comment

Looking at prunings on waterward shoulder and slope.

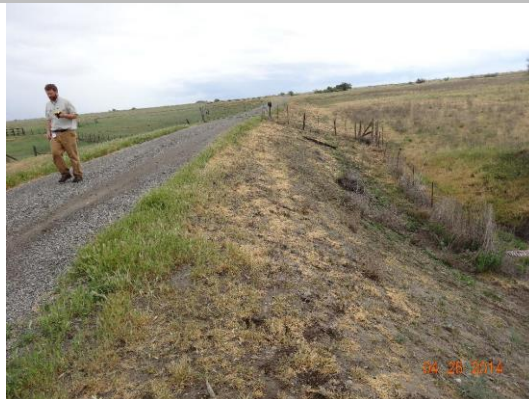
Photo 1 of 2 : UCIP_SP_2016_36246_65627.jpg

LM Start	18.79	Rating **	M	Issue No.	1245
LM End	18.79	Issue Type +	En	Location *	WS
Category	Supplemental			GPS Latitude/Longitude	
				Start	End
Item	DWR UCIP Field Study			37.204966 °	37.204966 °
				-120.762511 °	-120.762511 °
DWR ID					
Comment Code					
Inspector Comment					
FS_ID:36246 DS_ID:19593 EP_NO: N/A Repair Type: Non-Urgent Crossing Status: Found UCIP Comments: Dense vegetation limits the inspector's visibility to identify signs of pipe failure (leaks) along the landward slope. Recommend removing vegetation along pipe alignment to conduct proper inspection of structure. FIELD_STRUCT_DESC: 24-inch CM pipe through the levee, 12.0 feet below the crown. Flap gate on the waterward end. Brass cap No. 50 BM on headwall on the landward side. (USACE-1967). This entry matches the Drainage or Irrigation Structure referenced in O&M manual (HLM 18.79). FS Date: 4/25/2014

Overview of levee crown and waterward slope.

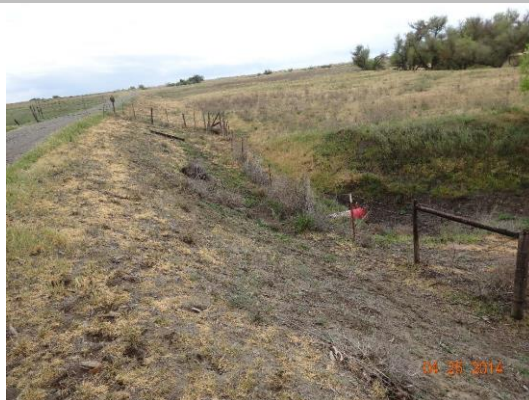
Photo 2 of 2 : UCIP_SP_2016_36246_65623.jpg

View of waterward side.

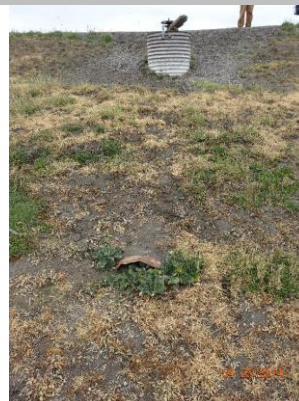
Photo 1 of 2 : UCIP_SP_2016_39263_65631.jpg

Comment Code					
Inspector Comment					
FS_ID:39263 DS_ID:19594 EP_NO: N/A Repair Type: Non-Urgent Crossing Status: Found UCIP Comments: Non-functional crossing--pipe is buried on waterward side. Sediment buildup in pipe visible from landward side. Need to coordinate with owner to determine status. If crossing is no longer in use, owner will need to coordinate with DWR Inspector and CVFPB to properly abandon. FIELD_STRUCT_DESC: 24-inch CM pipe through the levee, 13.0 feet below the crown. Slide gate on the waterward slope. Brass cap No. 40 BM on headwall on the landward side. (USACE-1967). This entry matches the Drainage or Irrigation Structure referenced in O&M manual (HLM 19.17). FS Date: 4/25/2014

View of waterward slope. CMP riser and pipe visible.

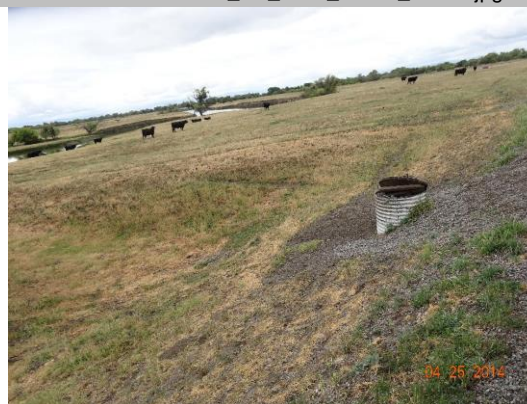
Photo 2 of 2 : UCIP_SP_2016_39263_65630.jpg

View of waterward side.

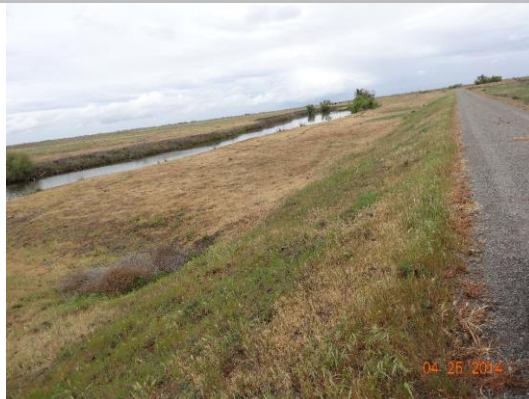
Photo 1 of 2 : UCIP_SP_2016_39268_65641.jpg

FS_ID:39268
DS_ID:19596
EP_NO: N/A
Repair Type: Non-Urgent
Crossing Status: Found
UCIP Comments: Dense vegetation limits the inspector's visibility to identify signs of pipe failure (leaks) along the waterward slope. Recommend removing vegetation along pipe alignment to conduct proper inspection of structure. Dense vegetation blocks both waterward and landward headwalls. Sediment buildup in pipe visible from landward side.
FIELD_STRUCT_DESC: 24-inch CM pipe through the levee, 8.0 feet below the crown. Flap gate on the waterward end. Brass cap No. 40 BM on headwall on the landward side. (USACE-1967). This entry matches the Drainage or Irrigation Structure referenced in O&M manual (HLM 19.54).
FS Date: 4/25/2014

View of waterward side.

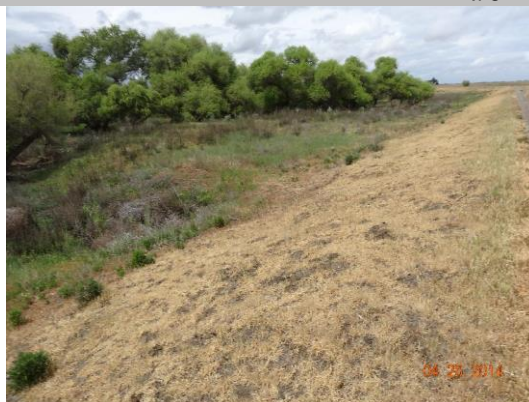
Photo 1 of 2 : UCIP_SP_2016_39269_65648.jpg

LM Start	20.18	Rating **	M	Issue No.	1232
LM End	20.18	Issue Type +	En	Location *	WS
Category	Supplemental			GPS Latitude/Longitude	
				Start	End
Item	DWR UCIP Field Study			37.194669 °	37.194669 °
				-120.759736 °	-120.759736 °
DWR ID					
Comment Code					
Inspector Comment					
FS_ID:39269 DS_ID:19598 EP_NO: N/A Repair Type: Non-Urgent Crossing Status: Found UCIP Comments: Recommend removing vegetation and sediment buildup from both waterward and landward concrete headwalls. FIELD_STRUCT_DESC: 24-inch CM pipe through the levee, 8.5 feet below the crown. Flap gate on the waterward end. Brass cap No. 40 BM on headwall on the landward side. (USACE-1967). This entry matches the Drainage or Irrigation Structure referenced in O&M manual (HLM 20.18). FS Date: 4/25/2014

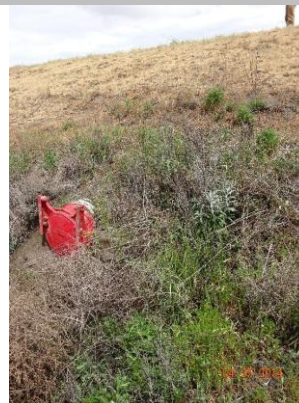
Photo 2 of 2 : UCIP_SP_2016_39269_65647.jpg

LM Start	20.18	Rating **	M	Issue No.	1232 (cont)	
LM End	20.18	Issue Type +	En	Location *	WS	
Category	Supplemental			GPS Latitude/Longitude		
				Start		End
Item	DWR UCIP Field Study			37.194669 °	37.194669 °	
				-120.759736 °	-120.759736 °	
DWR ID						
Comment Code						
Inspector Comment						
FS_ID:39269 DS_ID:19598 EP_NO: N/A Repair Type: Non-Urgent Crossing Status: Found UCIP Comments: Recommend removing vegetation and sediment buildup from both waterward and landward concrete headwalls. FIELD_STRUCT_DESC: 24-inch CM pipe through the levee, 8.5 feet below the crown. Flap gate on the waterward end. Brass cap No. 40 BM on headwall on the landward side. (USACE-1967). This entry matches the Drainage or Irrigation Structure referenced in O&M manual (HLM 20.18). FS Date: 4/25/2014

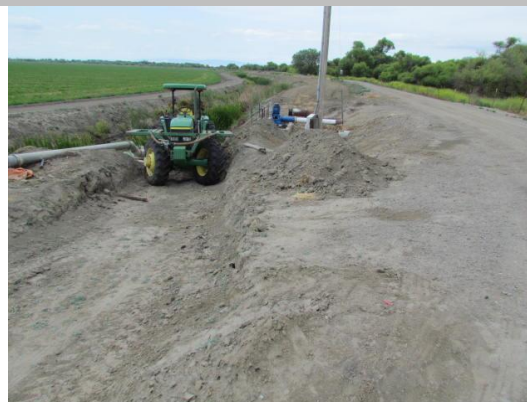
Photo 1 of 2 : SP_2016_NA0010_118_1184_20160512_00028.jpg

LM Start	20.25	Rating **	U	Issue No.	1184
LM End	20.25	Issue Type +	En	Location *	LS
Category	Earthen Levee			GPS Latitude/Longitude	
				Start	End
Item	Encroachments			37.193657 °	37.193657 °
				-120.760138 °	-120.760138 °
DWR ID	DWR_NA0010_01_s_2015_1184				
Comment Code					
RA : Ramp					
Inspector Comment					
Landowner installed unauthorized ramp on landward slope and toe.

Looking north at ramp cut into landward slope.

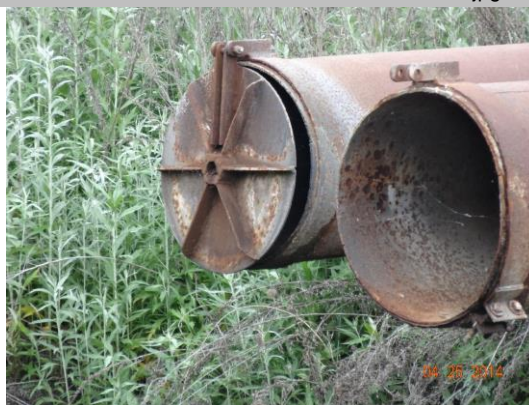
Photo 1 of 2 : UCIP_SP_2016_39285_71446.jpg

LM Start	20.26	Rating **	M	Issue No.	1241
LM End	20.26	Issue Type +	En	Location *	LS
Category	Supplemental			GPS Latitude/Longitude	
				Start	End
Item	DWR UCIP Field Study			37.193550 °	37.193550 °
				-120.760284 °	-120.760284 °
DWR ID					
Comment Code					
Inspector Comment					
FS_ID:39285 DS_ID:24873 EP_NO: N/A Repair Type: Non-Urgent Crossing Status: Found UCIP Comments: Dense vegetation limits the inspector's visibility to identify signs of pipe failure (leaks) along the waterward slope. Recommend removing vegetation along pipe alignment to conduct proper inspection of structure. FIELD_STRUCT_DESC: 12-inch steel sleeved into a 24-inch steel pipe through levee at an unknown depth. FS Date: 4/25/2014

Outlet visible on waterward side.

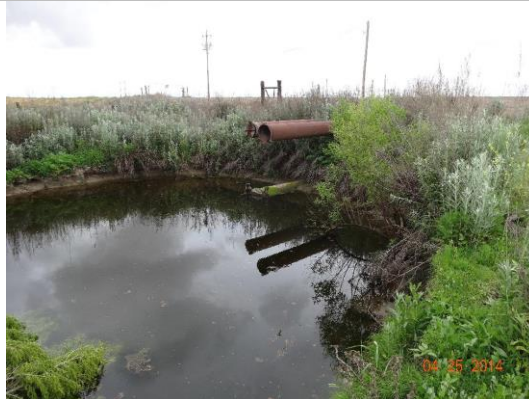
Photo 2 of 2 : UCIP_SP_2016_39285_71445.jpg

LM Start	20.26	Rating **	M	Issue No.	1241 (cont)
LM End	20.26	Issue Type +	En	Location *	LS
Category	Supplemental			GPS Latitude/Longitude	
				Start	End
Item	DWR UCIP Field Study			37.193550 °	37.193550 °
				-120.760284 °	-120.760284 °
DWR ID					
Comment Code					
Inspector Comment					
FS_ID:39285					
DS_ID:24873					
EP_NO: N/A					
Repair Type: Non-Urgent					
Crossing Status: Found					
UCIP Comments: Dense vegetation limits the inspector's visibility to identify signs of pipe failure (leaks) along the waterward slope.					
Recommend removing vegetation along pipe alignment to conduct proper inspection of structure.					
FIELD_STRUCT_DESC: 12-inch steel sleeved into a 24-inch steel pipe through levee at an unknown depth.					
FS Date: 4/25/2014

View of waterward side.

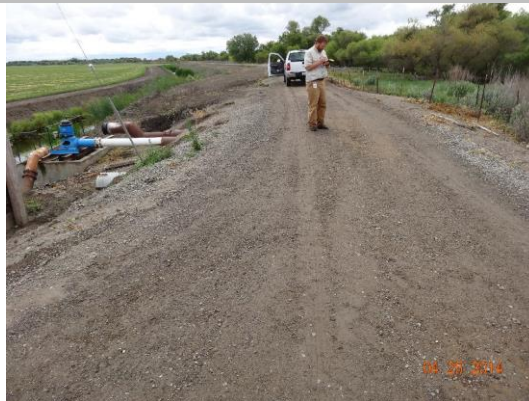
Photo 1 of 2 : UCIP_SP_2016_39270_66303.jpg

LM Start	20.27	Rating **	U	Issue No.	1233
LM End	20.27	Issue Type +	En	Location *	LS
Category	Supplemental			GPS Latitude/Longitude	
				Start	End
Item	DWR UCIP Field Study			37.193542 °	37.193542 °
				-120.760300 °	-120.760300 °
DWR ID					
Comment Code					
Inspector Comment					
FS_ID:39270 DS_ID:19599 EP_NO: N/A Repair Type: Urgent Crossing Status: Found UCIP Comments: Unauthorized crossing through pipe. Line was pushed through existing crossing. Need to contact owner. Also sediment buildup in pipe visible from landward side--recommend clearing. FIELD_STRUCT_DESC: 24-inch CM pipe through the levee, 5.0 feet below the crown. Flap gate on the waterward end. FS Date: 4/25/2014

Overview of levee crown at crossing.

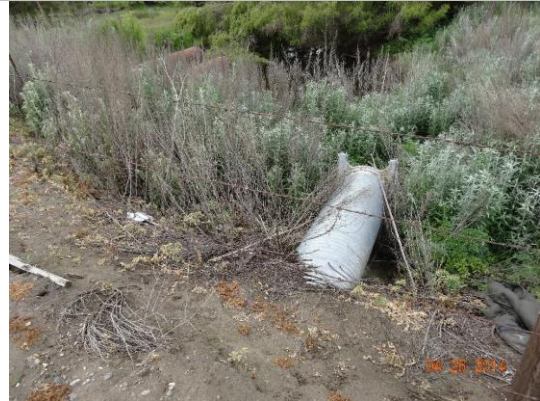
Photo 2 of 2 : UCIP_SP_2016_39270_66304.jpg

LM Start	20.27	Rating **	U	Issue No.	1233 (cont)	
LM End	20.27	Issue Type +	En	Location *	LS	
Category	Supplemental			GPS Latitude/Longitude		
				Start		End
Item	DWR UCIP Field Study			37.193542 °		37.193542 °
				-120.760300 °		-120.760300 °
DWR ID						
Comment Code						
Inspector Comment						
FS_ID:39270						
DS_ID:19599						
EP_NO: N/A						
Repair Type: Urgent						
Crossing Status: Found						
UCIP Comments: Unauthorized crossing through pipe. Line was pushed through existing crossing. Need to contact owner. Also sediment buildup in pipe visible from landward side--recommend clearing.						
FIELD_STRUCT_DESC: 24-inch CM pipe through the levee, 5.0 feet below the crown. Flap gate on the waterward end.						
FS Date: 4/25/2014

View of waterward side.

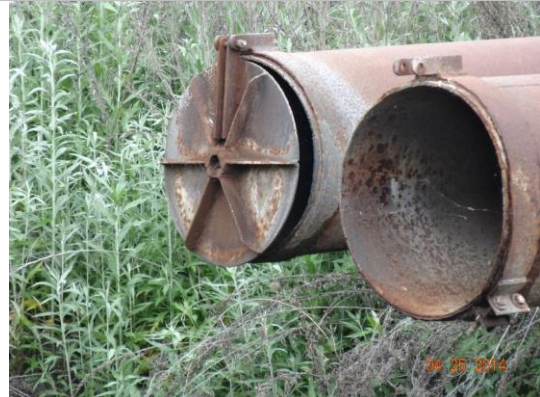
Photo 1 of 2 : UCIP_SP_2016_39286_71442.jpg

LM Start	20.27	Rating **	M	Issue No.	1242
LM End	20.27	Issue Type +	En	Location *	LS
Category	Supplemental			GPS Latitude/Longitude	
				Start	End
Item	DWR UCIP Field Study			37.193542 °	37.193542 °
				-120.760300 °	-120.760300 °
DWR ID					
Comment Code					
Inspector Comment					
FS_ID:39286					
DS_ID:24874					
EP_NO: N/A					
Repair Type: Non-Urgent					
Crossing Status: Found					
UCIP Comments: Dense vegetation limits the inspector's visibility to identify signs of pipe failure (leaks) along the waterward slope.					
Recommend removing vegetation along pipe alignment to conduct proper inspection of structure.					
FIELD_STRUCT_DESC: 18-inch steel sleeved into a 24-inch steel pipe through levee at an unknown depth.					
FS Date: 4/25/2014

Outlets visible on waterward side.
