**Flood Control Project Maintenance
Levee Inspections****LMA District Cover Sheet****Spring 2016 Levee Inspection Results****Lower San Joaquin Levee District**

Spring 2016 Levee Inspection Results

Lower San Joaquin Levee District

Waterway			Bank	Unit Miles
Unit No. 01 San Joaquin River			Right	22.52
	Spring (March - May)	Summer (June - August)	(September - November) Fall	Winter (December - February)
Unit Maintenance Rating (Fall Only)				
Date of Inspection	5/16/2016 - 5/19/2016			
DWR Inspector	Richard Willoughby			
Accompanied By

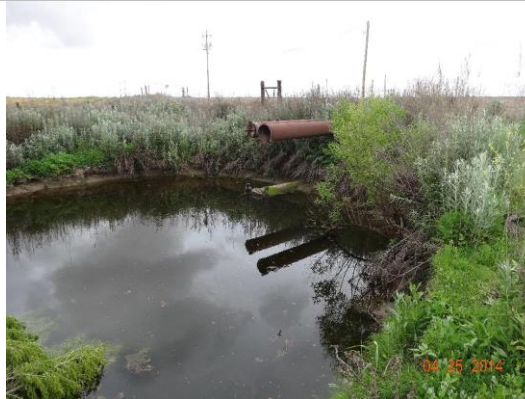
Photo 2 of 2 : UCIP_SP_2016_39286_71441.jpg

LM Start	20.27	Rating **	M	Issue No.	1242 (cont)
LM End	20.27	Issue Type +	En	Location *	LS
Category	Supplemental			GPS Latitude/Longitude	
				Start	End
Item	DWR UCIP Field Study			37.193542 °	37.193542 °
				-120.760300 °	-120.760300 °
DWR ID					
Comment Code					
Inspector Comment					
FS_ID:39286					
DS_ID:24874					
EP_NO: N/A					
Repair Type: Non-Urgent					
Crossing Status: Found					
UCIP Comments: Dense vegetation limits the inspector's visibility to identify signs of pipe failure (leaks) along the waterward slope.					
Recommend removing vegetation along pipe alignment to conduct proper inspection of structure.					
FIELD_STRUCT_DESC: 18-inch steel sleeved into a 24-inch steel pipe through levee at an unknown depth.					
FS Date: 4/25/2014

View of waterward side.

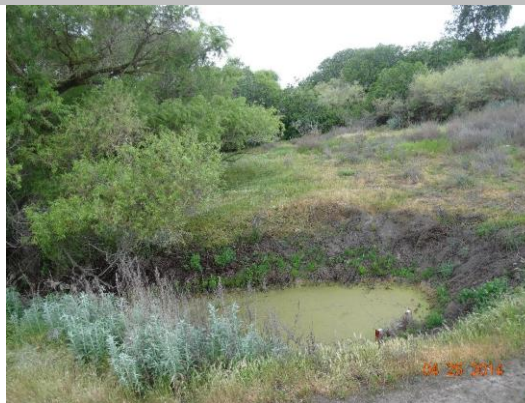
Photo 1 of 2 : UCIP_SP_2016_39271_66312.jpg

LM Start	21.40	Rating **	M	Issue No.	1234
LM End	21.40	Issue Type +	En	Location *	WS
Category	Supplemental			GPS Latitude/Longitude	
				Start	End
Item	DWR UCIP Field Study			37.179065 °	37.179065 °
				-120.761567 °	-120.761567 °
DWR ID					
Comment Code					
Inspector Comment					
FS_ID:39271 DS_ID:19603 EP_NO: N/A Repair Type: Non-Urgent Crossing Status: Found UCIP Comments: Crossing is non-functional--crossing buried on landward side. Need to contact owner to determine status of crossing. If crossing is no longer used need to coordinate with CVFPB for proper abandonment. FIELD_STRUCT_DESC: 36-inch CM pipe through the levee, 11.5 feet below the crown. Flap gate on the waterward end. Brass cap No. 40 BM on headwall on the landward side. (USACE-1967). This entry matches the Drainage or Irrigation Structure referenced in O&M manual (HLM 21.40). FS Date: 4/25/2014

View of waterward side.

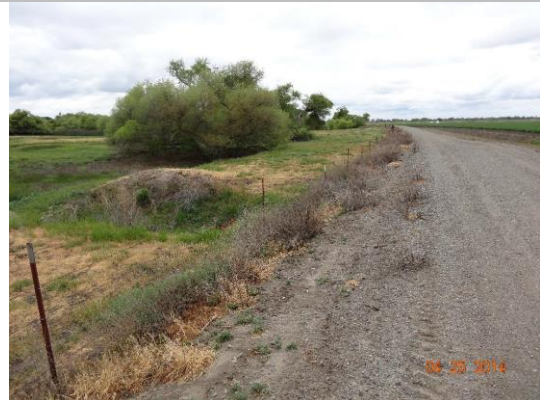
Photo 1 of 2 : UCIP_SP_2016_39272_65697.jpg

LM Start	21.75	Rating **	M	Issue No.	1239
LM End	21.75	Issue Type +	En	Location *	WS
Category	Supplemental			GPS Latitude/Longitude	
				Start	End
Item	DWR UCIP Field Study			37.176106 °	37.176106 °
				-120.756768 °	-120.756768 °
DWR ID					
Comment Code					
Inspector Comment					
FS_ID:39272 DS_ID:19604 EP_NO: N/A Repair Type: Non-Urgent Crossing Status: Found UCIP Comments: Non-functional crossing-landward side is buried. Need to contact owner to determine status of crossing. If crossing is no longer used need to coordinate with CVFPB for proper abandonment. FIELD_STRUCT_DESC: 24-inch CM pipe through the levee, 9.0 feet below the crown. Flap gate on the waterward end. Brass cap No. 40 BM on headwall on the landward side. (USACE-1967). This entry matches the Drainage or Irrigation Structure referenced in O&M manual (HLM 21.76). FS Date: 4/25/2014

View of waterward side.

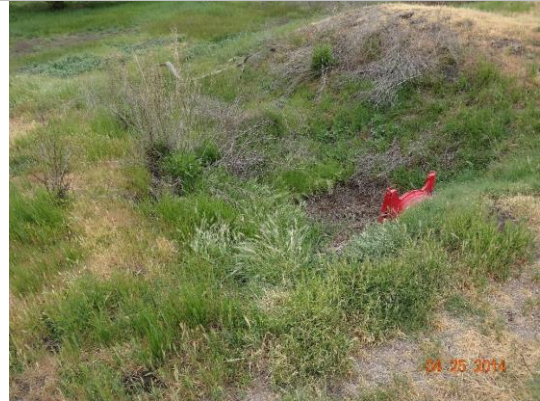
Photo 2 of 2 : UCIP_SP_2016_39272_65695.jpg

Comment Code					
Inspector Comment					
FS_ID:39272					
DS_ID:19604					
EP_NO: N/A					
Repair Type: Non-Urgent					
Crossing Status: Found					
UCIP Comments: Non-functional crossing-landward side is buried.					
Need to contact owner to determine status of crossing. If crossing is no					
longer used need to coordinate with CVFPB for proper abandonment.					
FIELD_STRUCT_DESC: 24-inch CM pipe through the levee, 9.0 feet					
below the crown. Flap gate on the waterward end. Brass cap No. 40 BM					
on headwall on the landward side. (USACE-1967). This entry matches					
the Drainage or Irrigation Structure referenced in O&M manual (HLM

Flap gate visible on waterward side.

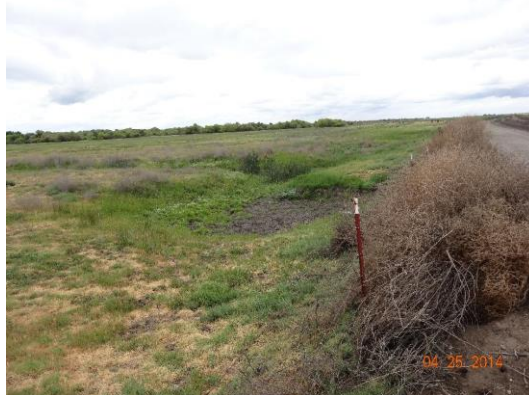
Photo 1 of 2 : UCIP_SP_2016_39273_65709.jpg

Comment Code					
Inspector Comment					
FS_ID:39273 DS_ID:19605 EP_NO: N/A Repair Type: Non-Urgent Crossing Status: Found UCIP Comments: Non-functional crossing--landward side is buried. Need to contact owner to determine status. If crossing is no longer used need to coordinate with CVFPB for proper abandonment. FIELD_STRUCT_DESC: 24-inch CM pipe through the levee, 9.0 feet below the crown. Flap gate on the waterward end. Wooden head- boards on the landward end of pipe. Brass cap No. 31 BM on headwall on the landward side. (USACE-1967). This entry matches the Drainage or Irrigation Structure referenced in O&M manual (HLM 22.13). FS Date: 4/25/2014

View of waterward side.

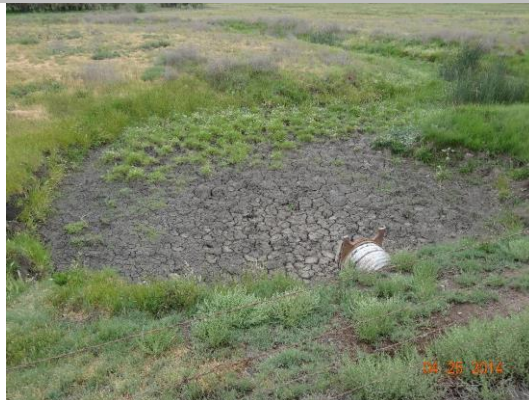
Photo 2 of 2 : UCIP_SP_2016_39273_65707.jpg

Flap gate visible on waterward side.

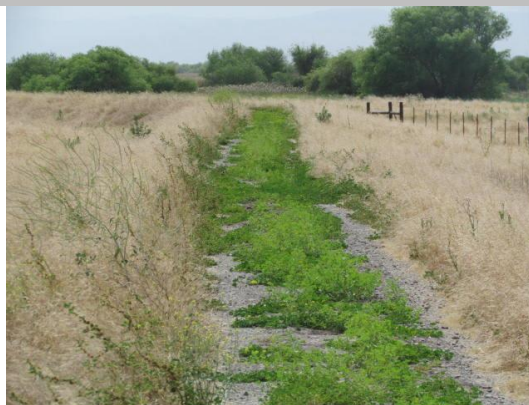
Photo 1 of 1 : SP_2016_NA0010_119_24_20160523_00065.jpg

LM Start	0.00	Rating **	M	Issue No.	24
LM End	2.30	Issue Type +	Ma	Location *	LS
Category	Earthen Levee			GPS Latitude/Longitude	
				Start	End
Item	Crown Surface / Depressions / Rutting			37.296313 °	37.291556 °
				-120.880576 °	-120.851252 °
DWR ID	DWR_NA0010_02A_s_2016_24				
Comment Code					
C1 : Add appropriate material and re-grade the levee to bring the crown above the design elevation.					
Inspector Comment					
Control annual weeds and regrade levee crown.

Looking northeast at veg on levee crown.

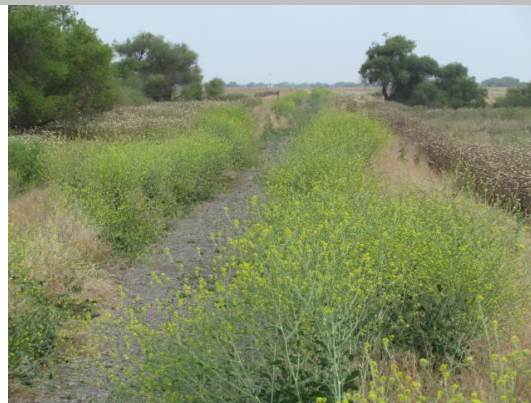
Photo 1 of 1 : SP_2016_NA0010_119_27_20160523_00070.jpg

LM Start	0.00	Rating **	U	Issue No.	27
LM End	2.30	Issue Type +	Ma	Location *	LS
Category	Earthen Levee			GPS Latitude/Longitude	
				Start	End
Item	Vegetation			37.296305 °	37.291556 °
				-120.880567 °	-120.851252 °
DWR ID	DWR_NA0010_02A_f_2015_27				
Comment Code					
V2 : Remove the wild growth other than native grasses from the levee slopes.					
Inspector Comment

Looking at dense veg on landward slope.

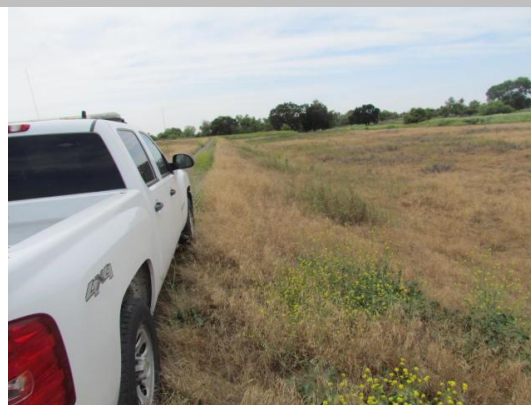
Photo 1 of 1 : SP_2016_NA0010_119_28_20160523_00071.jpg

LM Start	0.00	Rating **	U	Issue No.	28
LM End	2.30	Issue Type +	Ma	Location *	WS
Category	Earthen Levee			GPS Latitude/Longitude	
				Start	End
Item	Vegetation			37.296305 °	37.291556 °
				-120.880567 °	-120.851252 °
DWR ID	DWR_NA0010_02A_f _ 2015_28				
Comment Code					
V2 : Remove the wild growth other than native grasses from the levee slopes.					
Inspector Comment

Looking north at dense veg on waterward slope.

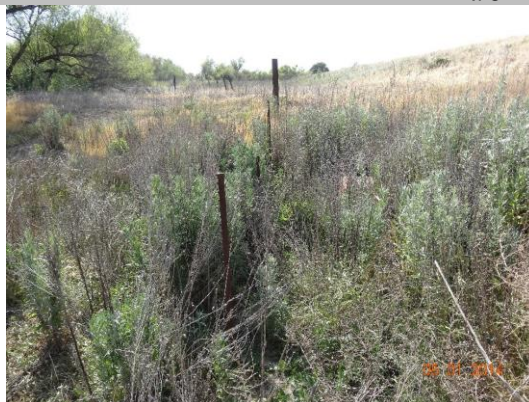
Photo 2 of 2 : UCIP_SP_2016_36503_66101.jpg

LM Start	0.23	Rating **	M	Issue No.	34
LM End	0.23	Issue Type +	En	Location *	WS
Category	Supplemental			GPS Latitude/Longitude	
				Start	End
Item	DWR UCIP Field Study			37.293440 °	37.293440 °
				-120.878978 °	-120.878978 °
DWR ID					
Comment Code					
Inspector Comment					
FS_ID:36503 DS_ID:19652 EP_NO: N/A Repair Type: Non-Urgent Crossing Status: Found UCIP Comments: Dense vegetation limits the inspector's visibility to identify signs of pipe failure (leaks) along the slope. Recommend removing vegetation along pipe alignment to conduct proper inspection of structure. FIELD_STRUCT_DESC: 24-inch CM pipe through the levee, 11.0 feet below the crown. Flap gate on the waterward end. Brass cap No. 139 BM on headwall on the landward side. (USACE-1967). This entry matches the Drainage or Irrigation Structure referenced in O&M manual (HLM 0.24). FS Date: 5/1/2014

Fence along waterward side. No headwall was found on waterward side.

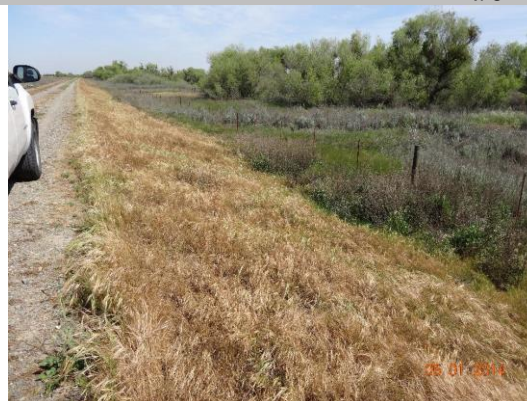
Photo 1 of 2 : UCIP_SP_2016_36504_66106.jpg

LM Start	0.66	Rating **	M	Issue No.	35
LM End	0.66	Issue Type +	En	Location *	WS
Category	Supplemental			GPS Latitude/Longitude	
				Start	End
Item	DWR UCIP Field Study			37.288087 °	37.288087 °
				-120.874919 °	-120.874919 °
DWR ID					
Comment Code					
Inspector Comment					
FS_ID:36504 DS_ID:19653 EP_NO: N/A Repair Type: Non-Urgent Crossing Status: Found UCIP Comments: Dense vegetation limits the inspector's visibility to identify signs of pipe failure (leaks) along the slope. Recommend removing vegetation along pipe alignment to conduct proper inspection of structure. FIELD_STRUCT_DESC: 24-inch CM pipe through the levee, 14.8 feet below the crown. Flap gate on the waterward end. Brass cap No. 138 BM on headwall on the landward side. (USACE-1967). This entry matches the Drainage or Irrigation Structure referenced in O&M manual (HLM 0.67). FS Date: 5/1/2014

View of waterward side.

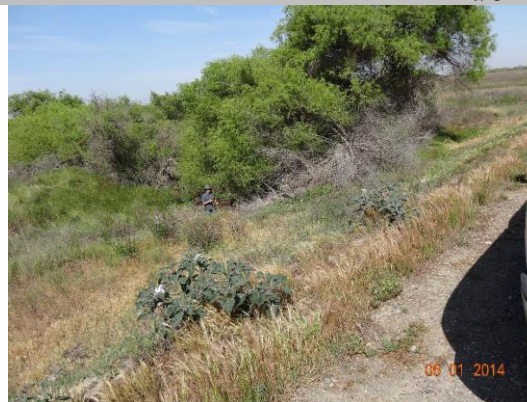
Photo 2 of 2 : UCIP_SP_2016_36504_66105.jpg

View of landward side.

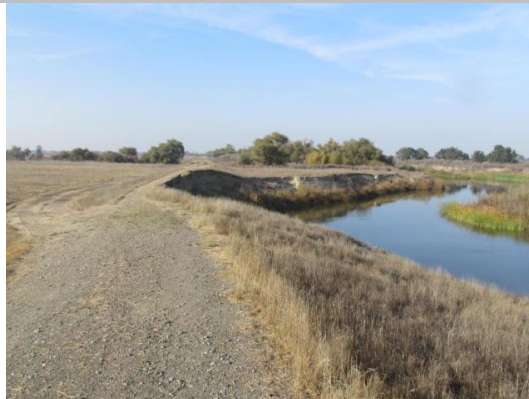
Photo 1 of 3 : SP_2016_NA0010_119_5_20160512_00003.jpg

LM Start	0.75	Rating **	U	Issue No.	5
LM End	0.75	Issue Type +	Ma	Location *	WS
Category	Earthen Levee			GPS Latitude/Longitude	
				Start	End
Item	Erosion / Bank Caving			37.286877 °	37.286877 °
				-120.874222 °	-120.874222 °
DWR ID	DWR_NA0010_02A_s_2012_5				
Comment Code					
E2 : Schedule repair of erosion site prior to the next inspection.					
Inspector Comment					
A field investigation report in on file. For more information and pictures see field investigation report #4301.

Looking north at erosion on waterward slope. (Fall 2014)

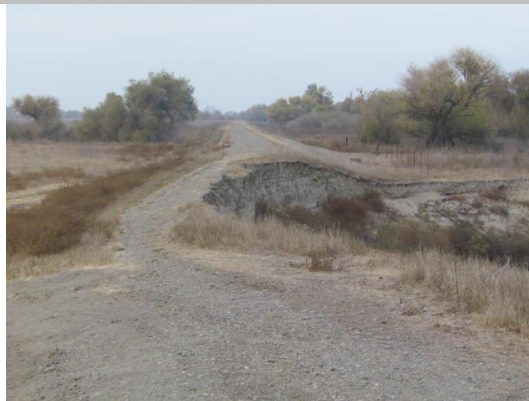
Photo 2 of 3 : SP_2016_NA0010_119_5_20160512_00004.jpg

Looking north at large erosion on waterward slope. (Fall 2013)

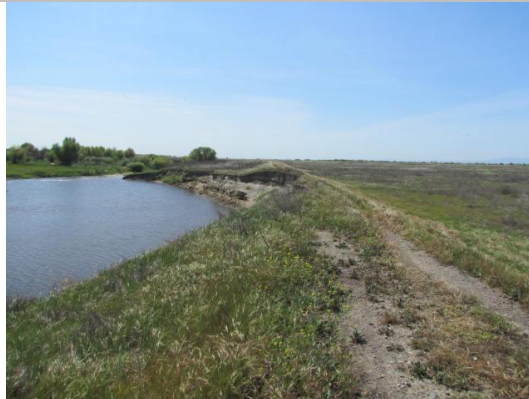
Photo 3 of 3 : SP_2016_NA0010_119_5_20160512_00005.jpg

Looking south at large erosion on waterside slope. (Spring 2012)

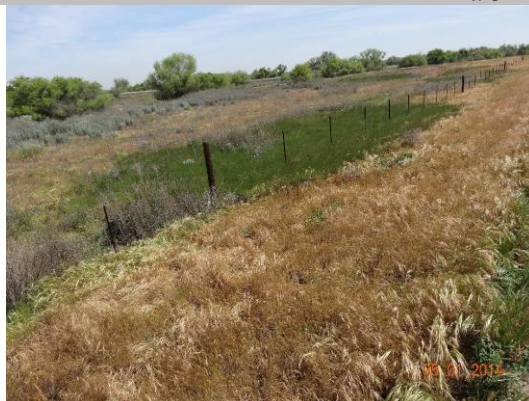
Photo 1 of 2 : UCIP_SP_2016_39363_66113.jpg

Comment Code					
Inspector Comment					
FS_ID:39363 DS_ID:19654 EP_NO: N/A Repair Type: Non-Urgent Crossing Status: Found UCIP Comments: Dense vegetation limits the inspector's visibility to identify signs of pipe failure (leaks) along the slope. Recommend removing vegetation along pipe alignment to conduct proper inspection of structure. Sediment buildup in pipe recommend clearing. FIELD_STRUCT_DESC: 24-inch CM pipe through the levee, 8.6 feet below the crown. Flap gate on the waterward end. Brass cap No. 137 BM on headwall on the landward side. (USACE-1967). This entry matches the Drainage or Irrigation Structure referenced in O&M manual (HLM 1.02). FS Date: 5/1/2014

View of waterward side.

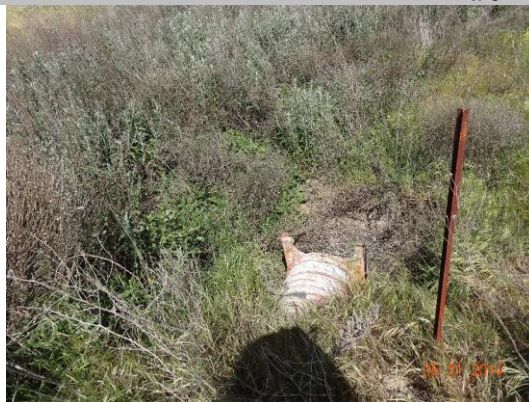
Photo 2 of 2 : UCIP_SP_2016_39363_66112.jpg

Pipe visible on waterward side.

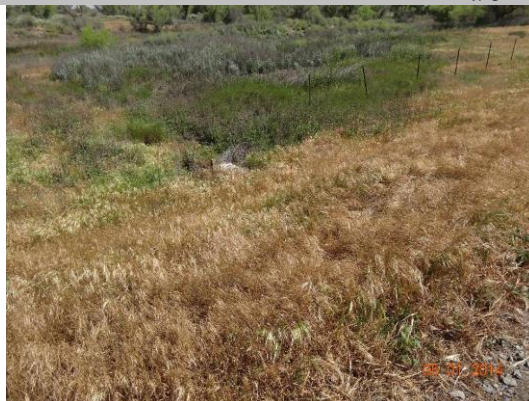
Photo 1 of 2 : UCIP_SP_2016_36506_66114.jpg

LM Start	1.21	Rating **	M	Issue No.	36
LM End	1.21	Issue Type +	En	Location *	WS
Category	Supplemental			GPS Latitude/Longitude	
				Start	End
Item	DWR UCIP Field Study			37.286118 °	37.286118 °
				-120.868167 °	-120.868167 °
DWR ID					
Comment Code					
Inspector Comment					
FS_ID:36506 DS_ID:19655 EP_NO: N/A Repair Type: Non-Urgent Crossing Status: Found UCIP Comments: Dense vegetation limits the inspector's visibility to identify signs of pipe failure (leaks) along the slope. Recommend removing vegetation along pipe alignment to conduct proper inspection of structure. FIELD_STRUCT_DESC: 24-inch CM pipe through the levee, 8.6 feet below the crown. Flap gate on the waterward end. Brass cap No. 136 BM on headwall on the landward side. (USACE-1967). This entry matches the Drainage or Irrigation Structure referenced in O&M manual (HLM 1.22). FS Date: 5/1/2014

Overview of waterward side.

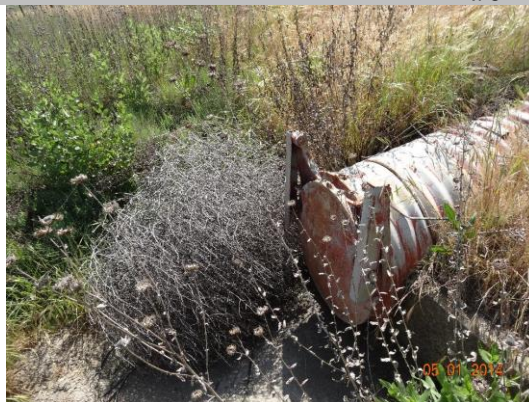
Photo 2 of 2 : UCIP_SP_2016_36506_66117.jpg

Flap gate visible on waterward side.

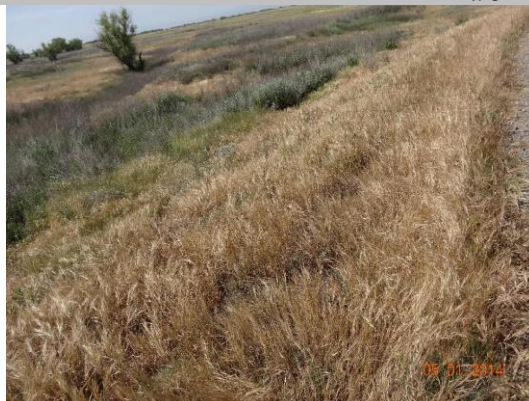
Photo 1 of 2 : UCIP_SP_2016_36507_66120.jpg

FS_ID:36507
DS_ID:19656
EP_NO: N/A
Repair Type: Non-Urgent
Crossing Status: Found
UCIP Comments: Dense vegetation limits the inspector's visibility to identify signs of pipe failure (leaks) along the slope. Recommend removing vegetation along pipe alignment to conduct proper inspection of structure.
FIELD_STRUCT_DESC: 36-inch CM pipe through the levee, 14.6 feet below the crown. Flap gate on the waterward end. Brass cap No. 135 BM on headwall on the landward side. (USACE-1967). This entry matches the Drainage or Irrigation Structure referenced in O&M manual (HLM 1.34).
FS Date: 5/1/2014

View of landward side.

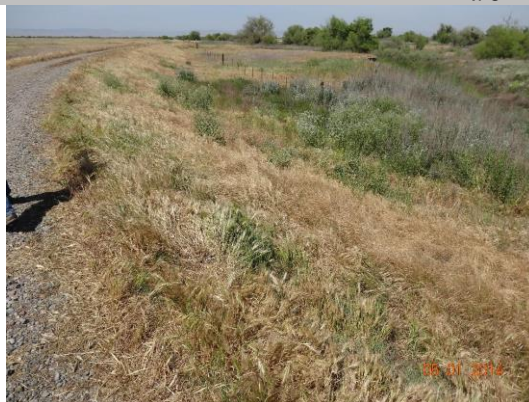
Photo 2 of 2 : UCIP_SP_2016_36507_66119.jpg

View of waterward side.

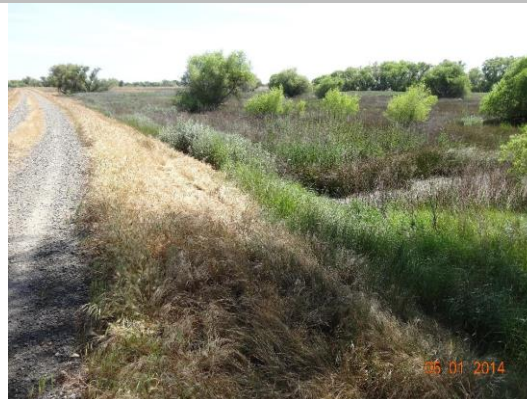
Photo 1 of 2 : UCIP_SP_2016_36508_66124.jpg

LM Start	1.61	Rating **	M	Issue No.	38
LM End	1.61	Issue Type +	En	Location *	WS
Category	Supplemental			GPS Latitude/Longitude	
				Start	End
Item	DWR UCIP Field Study			37.288599 °	37.288599 °
				-120.862007 °	-120.862007 °
DWR ID					
Comment Code					
Inspector Comment					
FS_ID:36508 DS_ID:19657 EP_NO: N/A Repair Type: Non-Urgent Crossing Status: Found UCIP Comments: Dense vegetation limits the inspector's visibility to identify signs of pipe failure (leaks) along the slope. Recommend removing vegetation along pipe alignment to conduct proper inspection of structure. FIELD_STRUCT_DESC: 24-inch CM pipe through the levee, 10.2 feet below the crown. Flap gate on the waterward end. Brass cap No. 135 BM on headwall on the landward side. (USACE-1967). This entry matches the Drainage or Irrigation Structure referenced in O&M manual (HLM 1.62). FS Date: 5/1/2014

Overview of landward side.

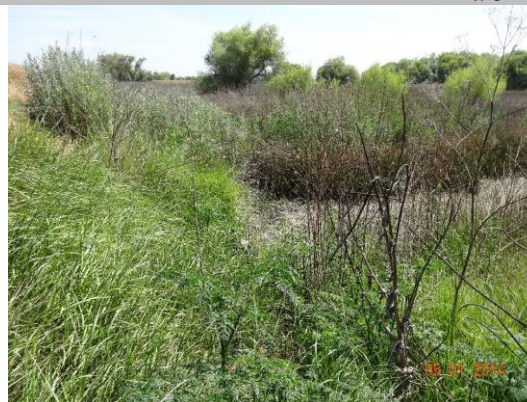
Photo 2 of 2 : UCIP_SP_2016_36508_66123.jpg

Dense vegetation along levee slope and toe.

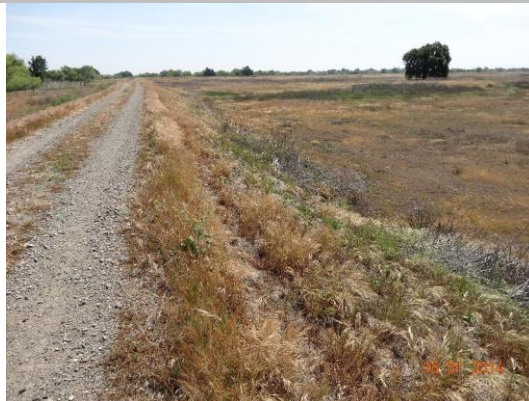
Photo 1 of 2 : UCIP_SP_2016_36509_66129.jpg

LM Start	1.85	Rating **	M	Issue No.	39
LM End	1.85	Issue Type +	En	Location *	WS
Category	Supplemental			GPS Latitude/Longitude	
				Start	End
Item	DWR UCIP Field Study			37.290836 °	37.290836 °
				-120.858882 °	-120.858882 °
DWR ID					
Comment Code					
Inspector Comment					
FS_ID:36509 DS_ID:19658 EP_NO: N/A Repair Type: Non-Urgent Crossing Status: Found UCIP Comments: Dense vegetation limits the inspector's visibility to identify signs of pipe failure (leaks) along the slope. Recommend removing vegetation along pipe alignment to conduct proper inspection of structure. FIELD_STRUCT_DESC: 24-inch CM pipe through the levee, 10.7 feet below the crown. Flap gate on the waterward end. Brass cap No. 135 BM on headwall on the landward side. (USACE-1967). This entry matches the Drainage or Irrigation Structure referenced in O&M manual (HLM 1.86). FS Date: 5/1/2014

View of landward side.

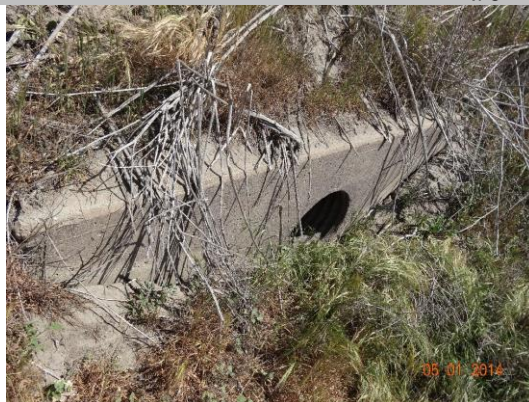
Photo 2 of 2 : UCIP_SP_2016_36509_66128.jpg

Concrete headwall visible on landward side.

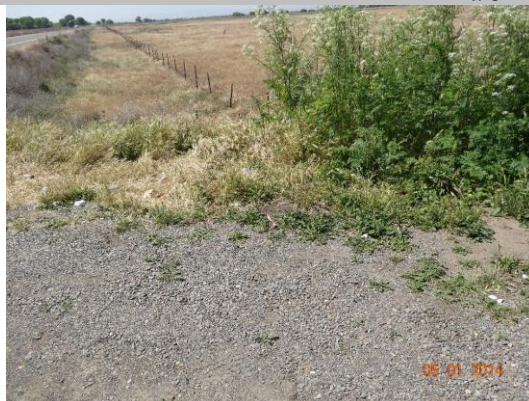
Photo 1 of 2 : UCIP_SP_2016_36510_66133.jpg

LM Start	2.28	Rating **	M	Issue No.	40
LM End	2.28	Issue Type +	En	Location *	WS
Category	Supplemental			GPS Latitude/Longitude	
				Start	End
Item	DWR UCIP Field Study			37.291686 °	37.291686 °
				-120.851475 °	-120.851475 °
DWR ID					
Comment Code					
Inspector Comment					
FS_ID:36510 DS_ID:19659 EP_NO: N/A Repair Type: Non-Urgent Crossing Status: Found UCIP Comments: Dense vegetation limits the inspector's visibility to identify signs of pipe failure (leaks) along the slope. Recommend removing vegetation along pipe alignment to conduct proper inspection of structure. FIELD_STRUCT_DESC: 24-inch CM pipe through the levee, 7.0 feet below the crown. Flap gate on the waterward end. Brass cap No. 135 BM on headwall on the landward side. (USACE-1967). This entry matches the Drainage or Irrigation Structure referenced in O&M manual (HLM 2.30). FS Date: 5/1/2014

View of landward side.

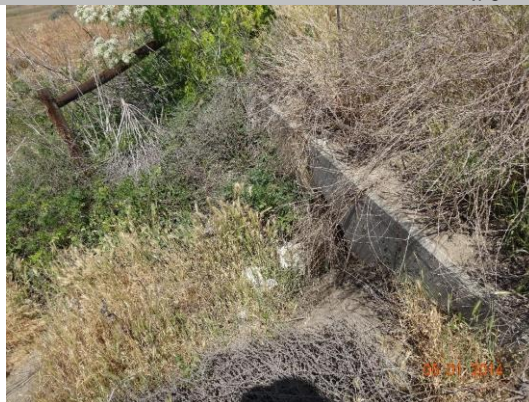
Photo 2 of 2 : UCIP_SP_2016_36510_66132.jpg

Concrete headwall visible on landward side.

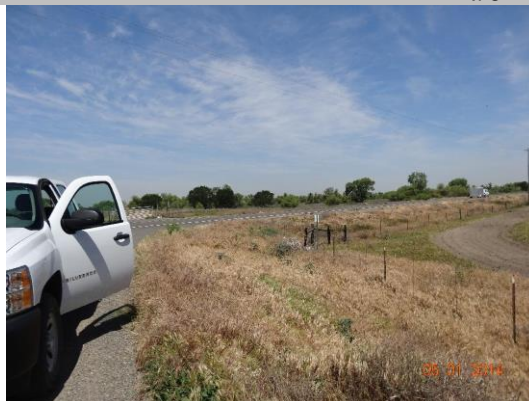
Photo 1 of 2 : UCIP_SP_2016_36511_66137.jpg

LM Start	2.30	Rating **	M	Issue No.	41
LM End	2.30	Issue Type +	En	Location *	WS
Category	Supplemental			GPS Latitude/Longitude	
				Start	End
Item	DWR UCIP Field Study			37.291532 °	37.291532 °
				-120.851203 °	-120.851203 °
DWR ID					
Comment Code					
Inspector Comment					
FS_ID:36511 DS_ID:19660 EP_NO: N/A Repair Type: Non-Urgent Crossing Status: Found UCIP Comments: Dense vegetation limits the inspector's visibility to identify signs of pipe failure (leaks) along the slope. Recommend removing vegetation along pipe alignment to conduct proper inspection of structure. FIELD_STRUCT_DESC: 24-inch CM pipe through the levee, 7.0 feet below the crown. Flap gate on the waterward end. Brass cap No. 135 BM on headwall on the landward side. (USACE-1967). This entry matches the Drainage or Irrigation Structure referenced in O&M manual (HLM 2.32). FS Date: 5/1/2014

View of waterward side.

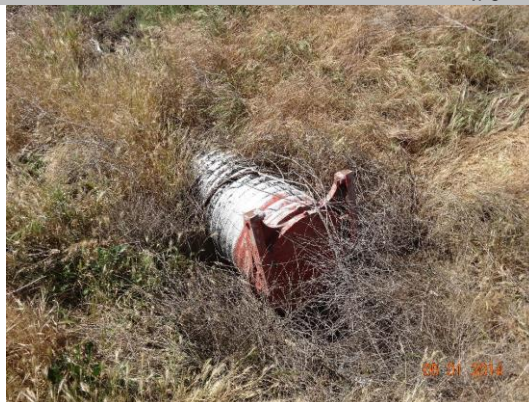
Photo 2 of 2 : UCIP_SP_2016_36511_66136.jpg

Flap gate visible on waterward side.

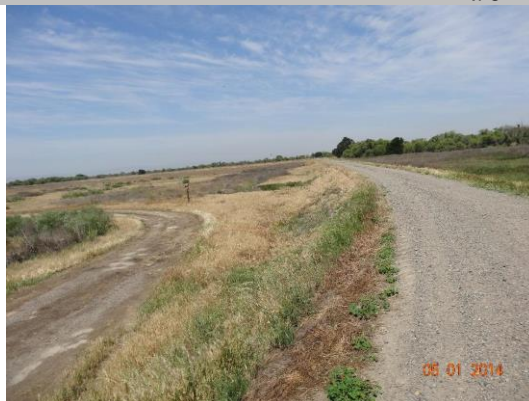
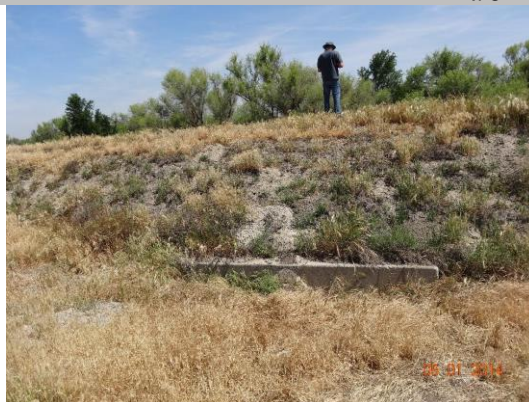
LM Start	2.58	Rating **	M	Issue No.	42
LM End	2.58	Issue Type +	En	Location *	LS
Category	Supplemental			GPS Latitude/Longitude	
				Start	End
Item	DWR UCIP Field Study			37.289487 °	37.289487 °
				-120.846941 °	-120.846941 °
DWR ID					
Comment Code					
Inspector Comment					
FS_ID:36512 DS_ID:19661 EP_NO: N/A Repair Type: Non-Urgent Crossing Status: Found UCIP Comments: Dense vegetation limits the inspector's visibility to identify signs of pipe failure (leaks) along the slope. Recommend removing vegetation along pipe alignment to conduct proper inspection of structure. FIELD_STRUCT_DESC: 24-inch CM pipe through the levee, 10.0 feet below the crown. Flap gate on the waterward end. Brass cap No. 130 BM on headwall on the landward side. (USACE-1967). This entry matches the Drainage or Irrigation Structure referenced in O&M manual (HLM 2.59). FS Date: 5/1/2014

View of landward side.

Concrete headwall visible on landward side.

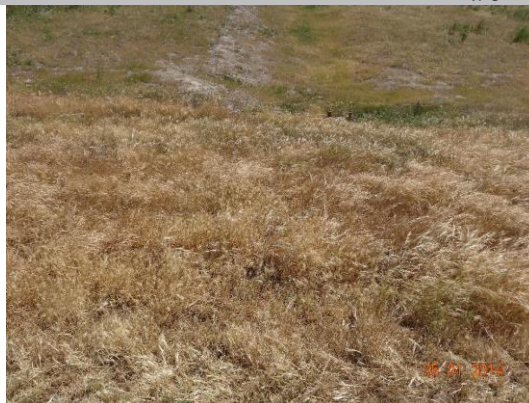
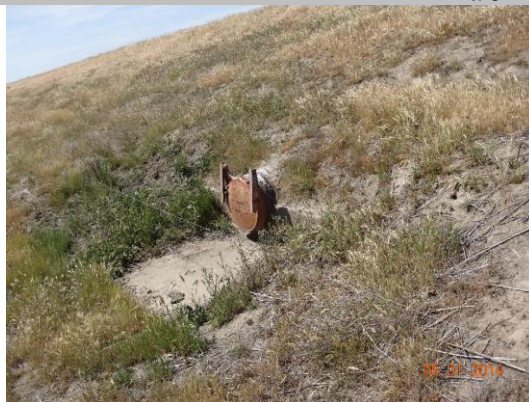
LM Start	2.95	Rating **	M	Issue No.	43
LM End	2.95	Issue Type +	En	Location *	LS
Category	Supplemental			GPS Latitude/Longitude	
				Start	End
Item	DWR UCIP Field Study			37.284326 °	37.284326 °
				-120.845157 °	-120.845157 °
DWR ID					
Comment Code					
Inspector Comment					
FS_ID:36513 DS_ID:19662 EP_NO: N/A Repair Type: Non-Urgent Crossing Status: Found UCIP Comments: Dense vegetation limits the inspector's visibility to identify signs of pipe failure (leaks) along the slope. Recommend removing vegetation along pipe alignment to conduct proper inspection of structure. FIELD_STRUCT_DESC: 24-inch CM pipe through the levee, 10.0 feet below the crown. Flap gate on the waterward end. Brass cap No. 130 BM on headwall on the landward side. (USACE-1967). This entry matches the Drainage or Irrigation Structure referenced in O&M manual (HLM 2.96). FS Date: 5/1/2014

View of waterward side.

Flap gate visible on waterward side.

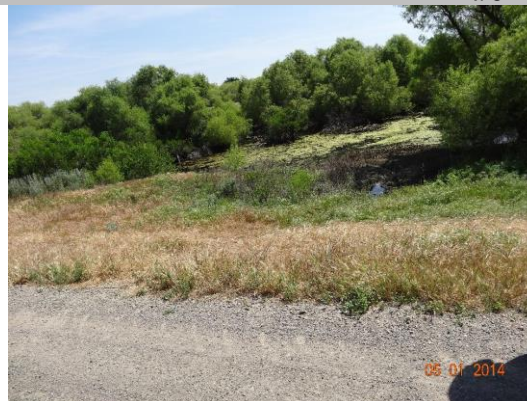
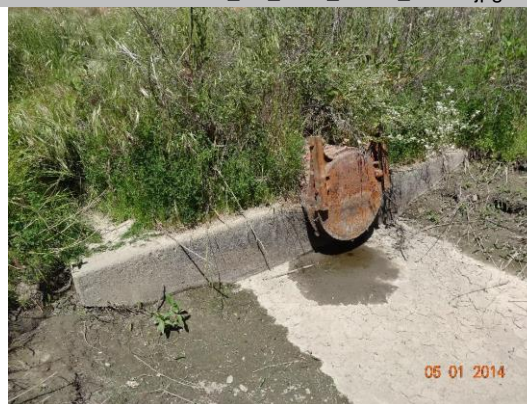
LM Start	3.28	Rating **	M	Issue No.	44
LM End	3.28	Issue Type +	En	Location *	LS
Category	Supplemental			GPS Latitude/Longitude	
				Start	End
Item	DWR UCIP Field Study			37.279656 °	37.279656 °
				-120.844795 °	-120.844795 °
DWR ID					
Comment Code					
Inspector Comment					
FS_ID:36514 DS_ID:19665 EP_NO: N/A Repair Type: Non-Urgent Crossing Status: Found UCIP Comments: Dense vegetation limits the inspector's visibility to identify signs of pipe failure (leaks) along the slope. Recommend removing vegetation along pipe alignment to conduct proper inspection of structure. FIELD_STRUCT_DESC: 24-inch CM pipe through the levee, 12.4 feet below the crown. Flap gate on the waterward end. Brass cap No. 130 BM on headwall on the landward side. (USACE-1967). This entry matches the Drainage or Irrigation Structure referenced in O&M manual (HLM 3.29). FS Date: 5/1/2014

View of waterward side.

Flap gate visible on waterward side.

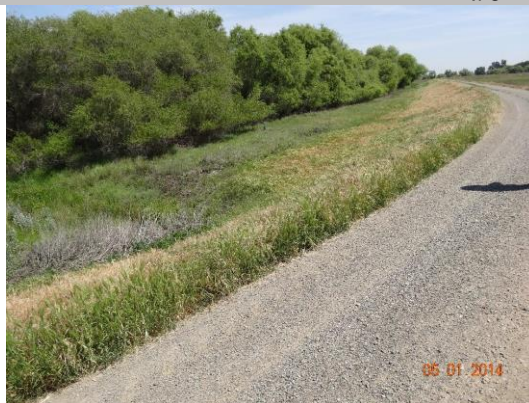
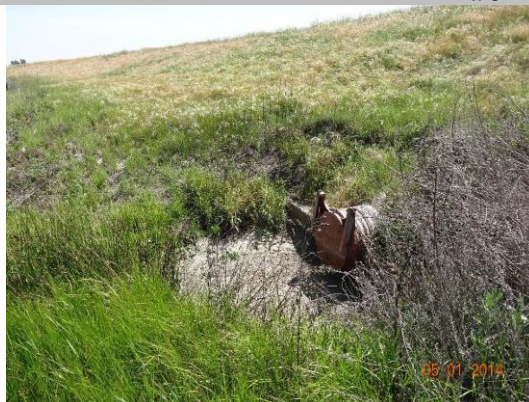
LM Start	3.61	Rating **	M	Issue No.	45
LM End	3.61	Issue Type +	En	Location *	LS
Category	Supplemental			GPS Latitude/Longitude	
				Start	End
Item	DWR UCIP Field Study			37.278203 °	37.278203 °
				-120.839884 °	-120.839884 °
DWR ID					
Comment Code					
Inspector Comment					
FS_ID:36515 DS_ID:19666 EP_NO: N/A Repair Type: Non-Urgent Crossing Status: Found UCIP Comments: Dense vegetation limits the inspector's visibility to identify signs of pipe failure (leaks) along the slope. Recommend removing vegetation along pipe alignment to conduct proper inspection of structure. FIELD_STRUCT_DESC: 24-inch CM pipe through the levee, 10.0 feet below the crown. Flap gate on the waterward end. Brass cap No. 130 BM on headwall on the landward side. (USACE-1967). This entry matches the Drainage or Irrigation Structure referenced in O&M manual (HLM 3.62). FS Date: 5/1/2014

View of waterward side.

Flap gate visible on waterward side.

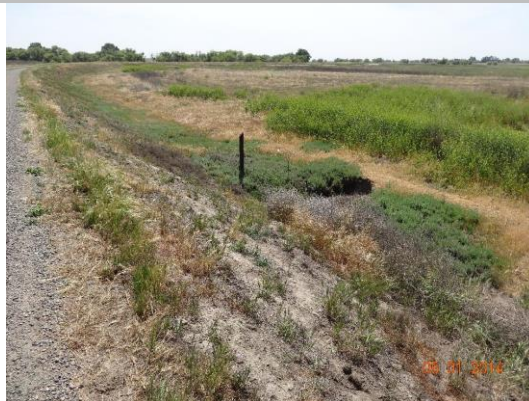
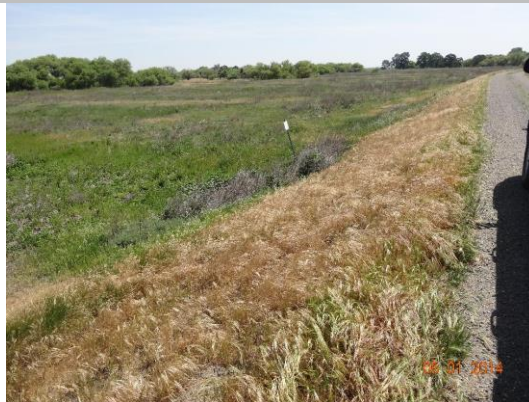
FS_ID:39364
DS_ID:19667
EP_NO: N/A
Repair Type: Non-Urgent
Crossing Status: Found
UCIP Comments: Signs of erosion or sink hole present on landward toe--Need to contact owner. Dense vegetation limits the inspector's visibility to identify signs of pipe failure (leaks) along the slope. Recommend removing vegetation along pipe alignment to conduct proper inspection of structure.
FIELD_STRUCT_DESC: 24-inch CM pipe through the levee, 8.6 feet below the crown. Flap gate on the waterward end. Brass cap No. 130 BM on headwall on the landward side. (USACE-1967). This entry matches the Drainage or Irrigation Structure referenced in O&M manual (HLM 3.95).
FS Date: 5/1/2014

View of landward side.

View of waterward side.

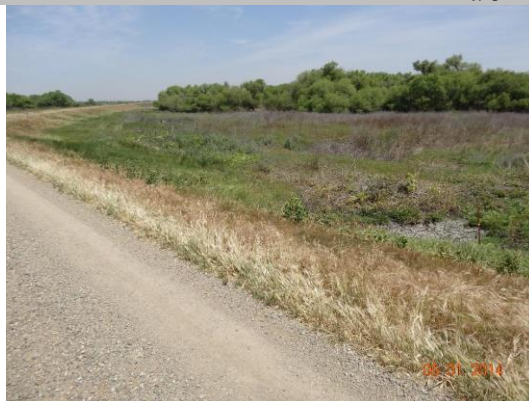
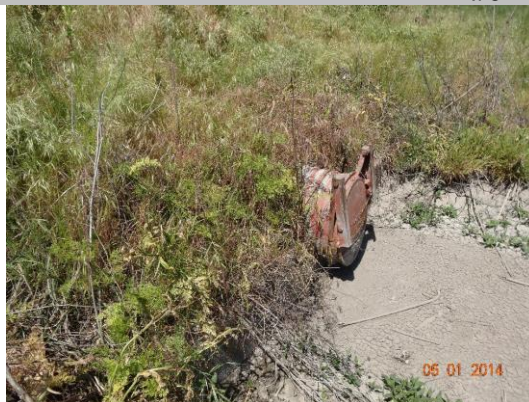
LM Start	5.41	Rating **	M	Issue No.	46
LM End	5.41	Issue Type +	En	Location *	LS
Category	Supplemental			GPS Latitude/Longitude	
				Start	End
Item	DWR UCIP Field Study			37.260069 °	37.260069 °
				-120.831768 °	-120.831768 °
DWR ID					
Comment Code					
Inspector Comment					
FS_ID:36517 DS_ID:19668 EP_NO: N/A Repair Type: Non-Urgent Crossing Status: Found UCIP Comments: Dense vegetation limits the inspector's visibility to identify signs of pipe failure (leaks) along the slope. Recommend removing vegetation along pipe alignment to conduct proper inspection of structure. FIELD_STRUCT_DESC: 24-inch CM pipe through the levee, 8.0 feet below the crown. Flap gate on the waterward end. Brass cap No. 125 BM on headwall on the landward side. (USACE-1967). This entry matches the Drainage or Irrigation Structure referenced in O&M manual (HLM 5.43). FS Date: 5/1/2014

View of waterward side.

Flap gate visible on waterward side.

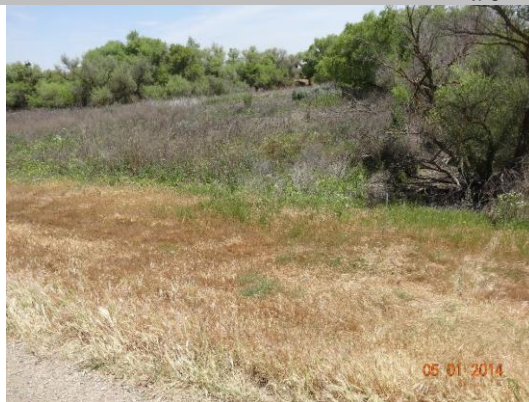
LM Start	6.03	Rating **	M	Issue No.	47
LM End	6.03	Issue Type +	En	Location *	LS
Category	Supplemental			GPS Latitude/Longitude	
				Start	End
Item	DWR UCIP Field Study			37.253527 °	37.253527 °
				-120.823991 °	-120.823991 °
DWR ID					
Comment Code					
Inspector Comment					
FS_ID:36518 DS_ID:19669 EP_NO: N/A Repair Type: Non-Urgent Crossing Status: Found UCIP Comments: Dense vegetation limits the inspector's visibility to identify signs of pipe failure (leaks) along the slope. Recommend removing vegetation along pipe alignment to conduct proper inspection of structure. FIELD_STRUCT_DESC: 24-inch CM pipe through the levee, 7.7 feet below the crown. Flap gate on the waterward end. Brass cap No. 125 BM on headwall on the landward side. (USACE-1967). This entry matches the Drainage or Irrigation Structure referenced in O&M manual (HLM 6.06). FS Date: 5/1/2014

View of landward side.

View of waterward side.

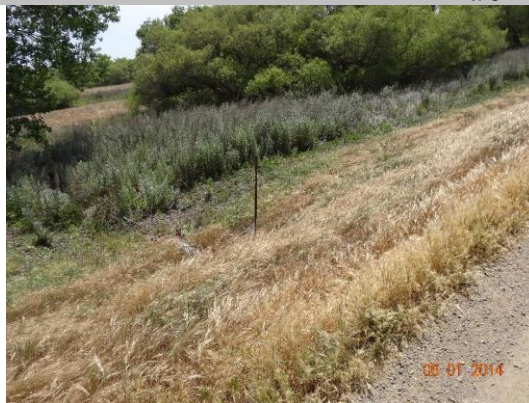
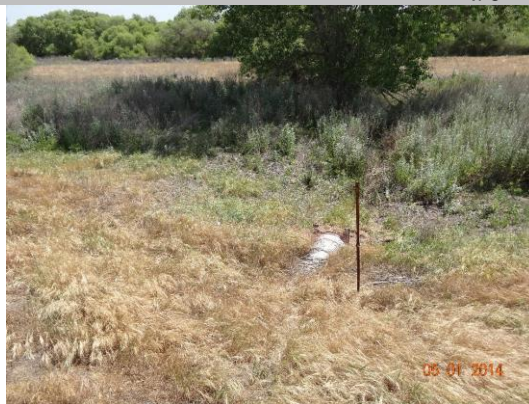
FS_ID:36519
DS_ID:19670
EP_NO: N/A
Repair Type: Non-Urgent
Crossing Status: Found
UCIP Comments: Dense vegetation limits the inspector's visibility to identify signs of pipe failure (leaks) along the slope. Recommend removing vegetation along pipe alignment to conduct proper inspection of structure.
FIELD_STRUCT_DESC: 24-inch CM pipe through the levee, 7.7 feet below the crown. Flap gate on the waterward end. Brass cap No. 125 BM on headwall on the landward side. (USACE-1967). This entry matches the Drainage or Irrigation Structure referenced in O&M manual (HLM 6.50).
FS Date: 5/1/2014

View of waterward side.

Crossing and flap gate visible on waterward side.

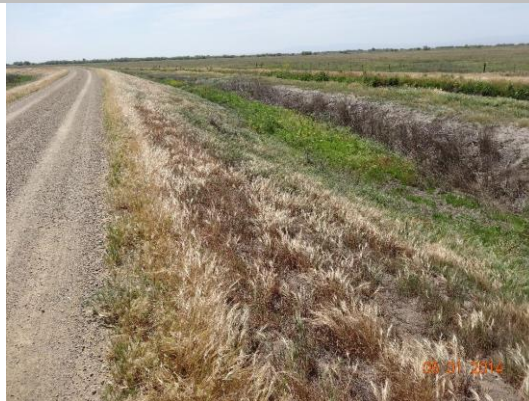
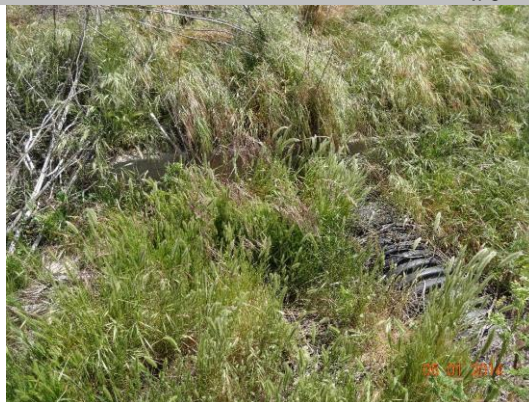
FS_ID:39365
DS_ID:19671
EP_NO: N/A
Repair Type: Non-Urgent
Crossing Status: Found
UCIP Comments: Dense vegetation limits the inspector's visibility to identify signs of pipe failure (leaks) along the slope. Recommend removing vegetation along pipe alignment to conduct proper inspection of structure. Pipe extension visible on landward side--need to contact owner for additional information about extension/modification.
FIELD_STRUCT_DESC: 24-inch CM pipe through the levee, 12.6 feet below the crown. Flap gate on the waterward end. Brass cap No. 125 BM on headwall on the landward side. (USACE-1967). This entry matches the Drainage or Irrigation Structure referenced in O&M manual (HLM 7.05).
FS Date: 5/1/2014

View of landward side.

Pipe extension visible on landward side attached to inlet at concrete headwall.

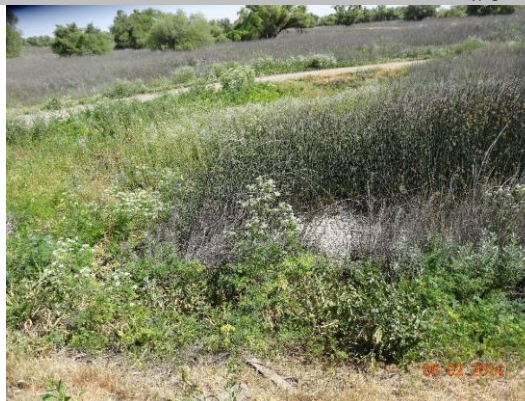
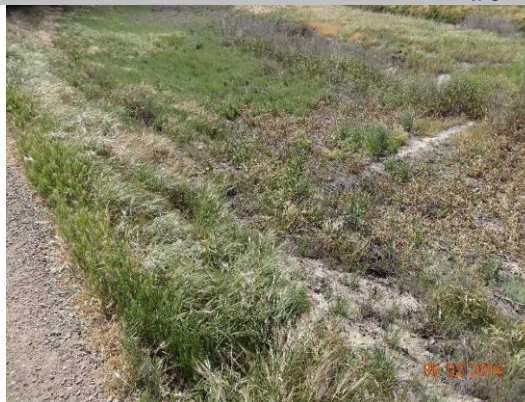
LM Start	7.74	Rating **	M	Issue No.	30
LM End	7.74	Issue Type +	En	Location *	LS
Category	Supplemental			GPS Latitude/Longitude	
				Start	End
Item	DWR UCIP Field Study			37.232650 °	37.232650 °
				-120.813363 °	-120.813363 °
DWR ID					
Comment Code					
Inspector Comment					
FS_ID:36521 DS_ID:19673 EP_NO: N/A Repair Type: Non-Urgent Crossing Status: Found UCIP Comments: Dense vegetation limits the inspector's visibility to identify signs of pipe failure (leaks) along the slope. Recommend removing vegetation along pipe alignment to conduct proper inspection of structure. FIELD_STRUCT_DESC: 24-inch CM pipe through the levee, 8.0 feet below the crown. Flap gate on the waterward end. Brass cap No. 125 BM on headwall on the landward side. (USACE-1967). This entry matches the Drainage or Irrigation Structure referenced in O&M manual (HLM 7.77). FS Date: 5/1/2014

View of waterward side.

View of landward side.

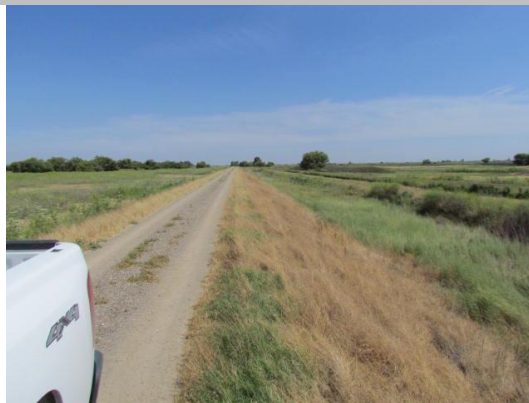
Photo 1 of 1 : SP_2016_NA0010_120_17_20160523_00006.jpg

LM Start	7.87	Rating **	M	Issue No.	17
LM End	13.75	Issue Type +	Ma	Location *	LS
Category	Earthen Levee			GPS Latitude/Longitude	
				Start	End
Item	Vegetation			37.231291 °	37.172165 °
				-120.811871 °	-120.761208 °
DWR ID	DWR_NA0010_02B_s_2016_17				
Comment Code					
V1 : Control annual grass and weeds on the levee slopes and easements.					
Inspector Comment

Looking at typical view of landward slope.

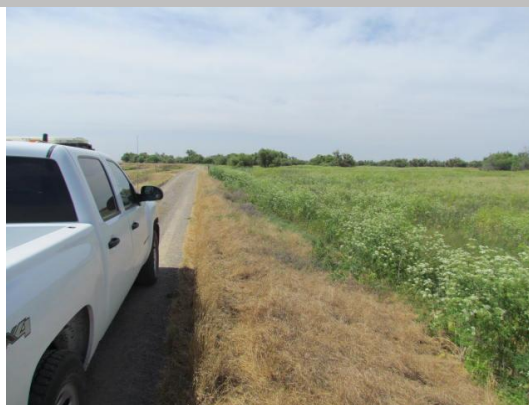
Photo 1 of 1 : SP_2016_NA0010_120_18_20160523_00007.jpg

LM Start	7.87	Rating **	M	Issue No.	18
LM End	13.75	Issue Type +	Ma	Location *	WS
Category	Earthen Levee			GPS Latitude/Longitude	
				Start	End
Item	Vegetation			37.231291 °	37.172166 °
				-120.811871 °	-120.761209 °
DWR ID	DWR_NA0010_02B_s_2016_18				
Comment Code					
V1 : Control annual grass and weeds on the levee slopes and easements.					
Inspector Comment

Looking north at typical view of waterward slope.

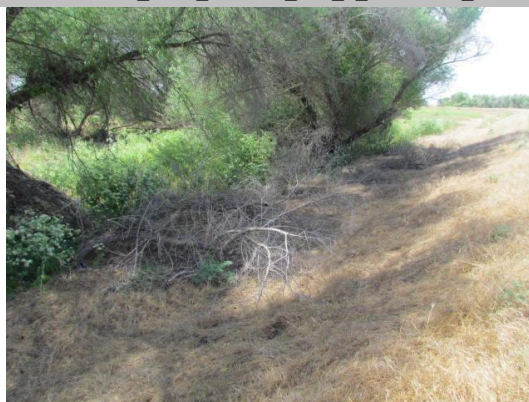
Photo 1 of 1 : SP_2016_NA0010_120_5_20160523_00008.jpg

LM Start	9.76	Rating **	M	Issue No.	5
LM End	9.76	Issue Type +	Ma	Location *	LS
Category	Earthen Levee			GPS Latitude/Longitude	
				Start	End
Item	Encroachments			37.218959 °	37.218959 °
				-120.784356 °	-120.784356 °
DWR ID	DWR_NA0010_02B_s_2016_5				
Comment Code					
TR : Tree or limb					
Inspector Comment					
Broken tree limbs on landward toe.

Looking northwest at broken tree limb on landward toe.

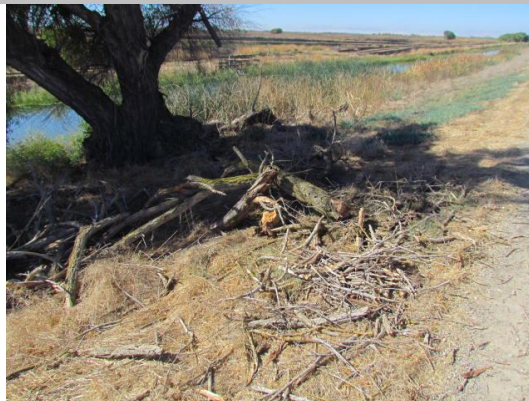
Photo 1 of 1 : SP_2016_NA0010_120_14_20160512_00005.jpg

LM Start	10.94	Rating **	M	Issue No.	14
LM End	10.94	Issue Type +	Ma	Location *	LS
Category	Earthen Levee			GPS Latitude/Longitude	
				Start	End
Item	Encroachments			37.205711 °	37.205711 °
				-120.774741 °	-120.774741 °
DWR ID	DWR_NA0010_02B_f_2015_14				
Comment Code					
PR : Prunings					
Inspector Comment					
Prunings on landward slope.

Looking at prunings on landward slope.

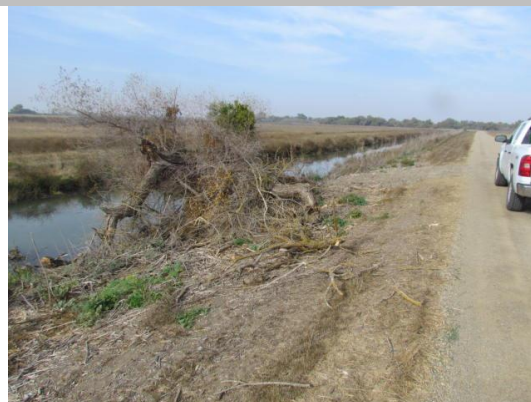
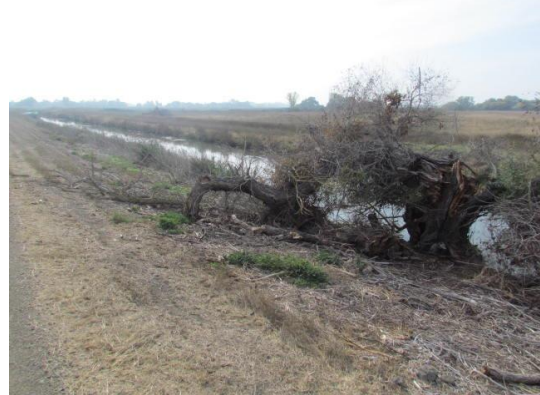
LM Start	12.21	Rating **	M	Issue No.	1
LM End	12.21	Issue Type +	Ma	Location *	LS
Category	Earthen Levee			GPS Latitude/Longitude	
				Start	End
Item	Encroachments			37.191528 °	37.191528 °
				-120.764541 °	-120.764541 °
DWR ID	DWR_NA0010_02B_f_2014_1				
Comment Code					
TR : Tree or limb					
Inspector Comment					
Fallen tree limbs on landward slope.

Looking southwest at tree limb on waterward slope.

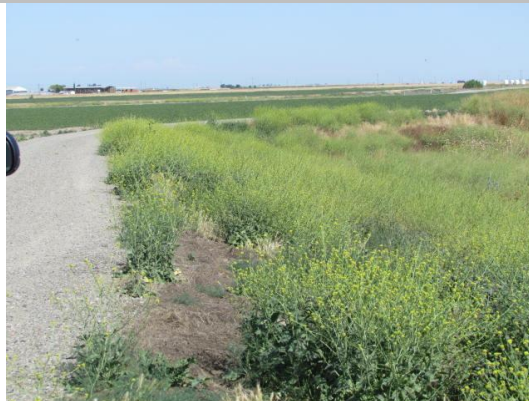
Photo 1 of 1 : SP_2016_NA0010_121_7_20160523_00012.jpg

LM Start	0.00	Rating **	M	Issue No.	7
LM End	2.09	Issue Type +	Ma	Location *	WS
Category	Earthen Levee			GPS Latitude/Longitude	
				Start	End
Item	Vegetation			37.111700 °	37.088992 °
				-120.587580 °	-120.566894 °
DWR ID	DWR_NA0010_03_s _ 2016_7				
Comment Code					
V1 : Control annual grass and weeds on the levee slopes and easements.					
Inspector Comment

Looking east at veg on waterward slope.

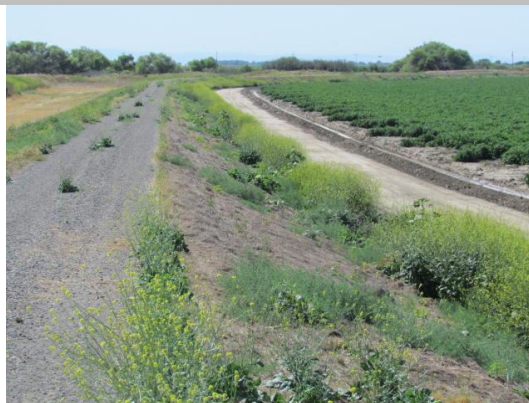
Photo 1 of 1 : SP_2016_NA0010_121_5_20160523_00013.jpg

LM Start	0.00	Rating **	M	Issue No.	5
LM End	2.09	Issue Type +	Ma	Location *	LS
Category	Earthen Levee			GPS Latitude/Longitude	
				Start	End
Item	Vegetation			37.111699 °	37.088993 °
				-120.587580 °	-120.566895 °
DWR ID	DWR_NA0010_03_s _ 2016_5				
Comment Code					
V1 : Control annual grass and weeds on the levee slopes and easements.					
Inspector Comment

Looking west at landward slope.

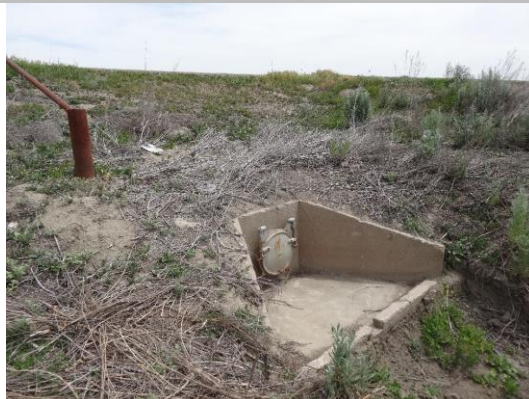
Photo 1 of 2 : UCIP_SP_2016_34083_61941.jpg

Concrete structure and flap gate visible on waterward side.

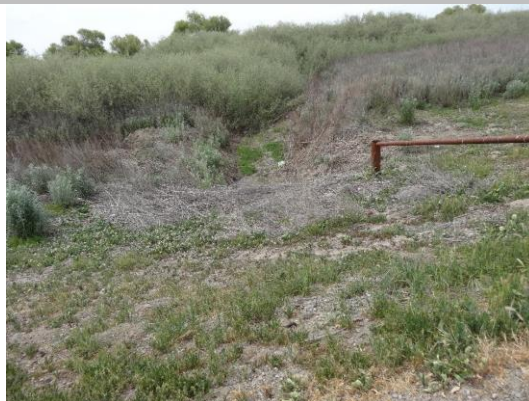
Photo 2 of 2 : UCIP_SP_2016_34083_61940.jpg

LM Start	0.42	Rating **	M	Issue No.	68
LM End	0.42	Issue Type +	En	Location *	LS
Category	Supplemental			GPS Latitude/Longitude	
				Start	End
Item	DWR UCIP Field Study			37.106233 °	37.106233 °
				-120.585797 °	-120.585797 °
DWR ID					
Comment Code					
Inspector Comment					
FS_ID:34083 DS_ID:19691 EP_NO: N/A Repair Type: Non-Urgent Crossing Status: Found UCIP Comments: Need to contact owner. Recommend removing tall grass on landward slope and clearing sediment build up inside pipe. FIELD_STRUCT_DESC: 24-inch CM pipe through the levee, 11.3 feet below the crown. Flap gate on the waterward end. (USACE-1967). This entry matches the Drainage or Irrigation Structure referenced in O&M manual (HLM 0.43). FS Date: 4/17/2014

View of waterward side.

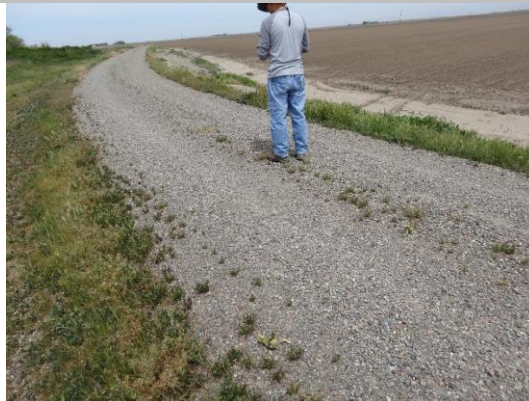
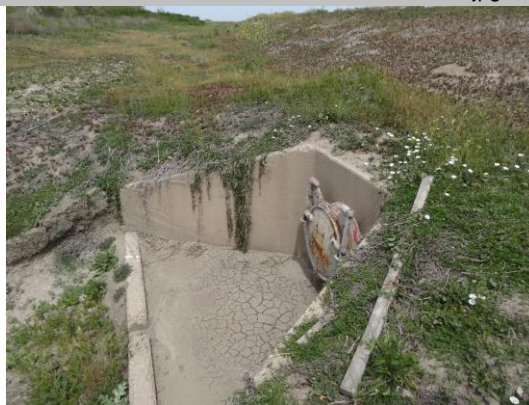
LM Start	1.71	Rating **	M	Issue No.	69
LM End	1.71	Issue Type +	En	Location *	LS
Category	Supplemental			GPS Latitude/Longitude	
				Start	End
Item	DWR UCIP Field Study			37.092079 °	37.092079 °
				-120.572316 °	-120.572316 °
DWR ID					
Comment Code					
Inspector Comment					
FS_ID:39371 DS_ID:19693 EP_NO: N/A Repair Type: Non-Urgent Crossing Status: Found UCIP Comments: Sediment buildup in pipe visible from landward side--recommend clearing. FIELD_STRUCT_DESC: 24-inch CM pipe through the levee, 6.8 feet below the crown. Flap gate on the waterward end. (USACE-1967). This entry matches the Drainage or Irrigation Structure referenced in O&M manual (HLM 1.72). FS Date: 4/17/2014

View of levee crown at crossing.

Concrete structure located on waterward side.

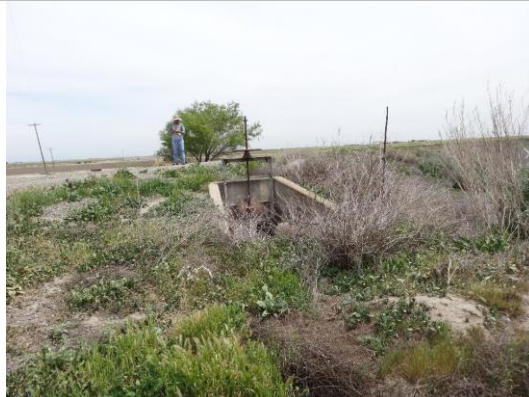
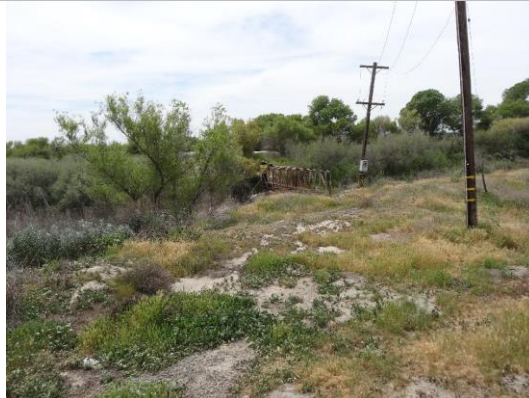
LM Start	2.04	Rating **	M	Issue No.	70
LM End	2.04	Issue Type +	En	Location *	LS
Category	Supplemental			GPS Latitude/Longitude	
				Start	End
Item	DWR UCIP Field Study			37.089394 °	37.089394 °
				-120.567731 °	-120.567731 °
DWR ID					
Comment Code					
Inspector Comment					
FS_ID:36543 DS_ID:19694 EP_NO: N/A Repair Type: Non-Urgent Crossing Status: Found UCIP Comments: Need to contact owner--additional appurtenances found on waterward side not part of original description. Unable to determine if walkway, pump, and pipe through waterward berm is if part of original crossing. FIELD_STRUCT_DESC: 36-inch CM pipe through the levee, 6.6 feet below the crown. Slide gate on the waterward end. Pump on the waterward bank. (USACE-1967). This entry matches the Drainage or Irrigation Structure referenced in O&M manual (HLM 2.05). FS Date: 4/17/2014

Slide gate and concrete structure located on waterward slope.

View of walkway and berm on waterward side.

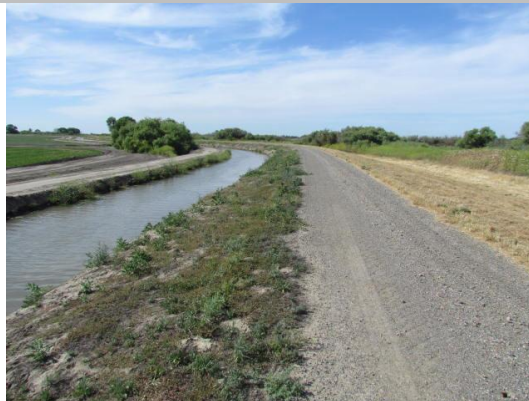
Photo 1 of 1 : SP_2016_NA0010_122_11_20160523_00026.jpg

LM Start	0.00	Rating **	M	Issue No.	11
LM End	1.41	Issue Type +	Ma	Location *	LS
Category	Earthen Levee			GPS Latitude/Longitude	
				Start	End
Item	Vegetation			37.112579 °	37.097555 °
				-120.589106 °	-120.578130 °
DWR ID	DWR_NA0010_04_s_2016_11				
Comment Code					
V1 : Control annual grass and weeds on the levee slopes and easements.					
Inspector Comment

Looking southeast at landward slope.

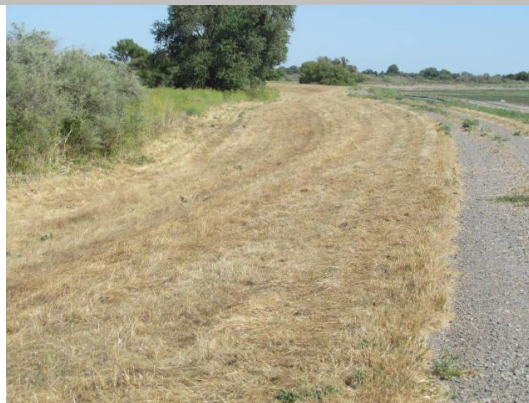
Photo 1 of 1 : SP_2016_NA0010_122_12_20160523_00025.jpg

LM Start	0.00	Rating **	A	Issue No.	12
LM End	1.41	Issue Type +	Ma	Location *	WS
Category	Earthen Levee			GPS Latitude/Longitude	
				Start	End
Item	Vegetation			37.112579 °	37.097555 °
				-120.589106 °	-120.578130 °
DWR ID	DWR_NA0010_04_s_2016_12				
Comment Code					
V1 : Control annual grass and weeds on the levee slopes and easements.					
Inspector Comment

Looking north at waterward slope.
