**Flood Control Project Maintenance
Levee Inspections****LMA District Cover Sheet****Spring 2016 Levee Inspection Results****Lower San Joaquin Levee District**

Spring 2016 Levee Inspection Results

Lower San Joaquin Levee District

Waterway			Bank	Unit Miles
Unit No. 01 San Joaquin River			Right	22.52
	Spring (March - May)	Summer (June - August)	(September - November) Fall	Winter (December - February)
Unit Maintenance Rating (Fall Only)				
Date of Inspection	5/16/2016 - 5/19/2016			
DWR Inspector	Richard Willoughby			
Accompanied By

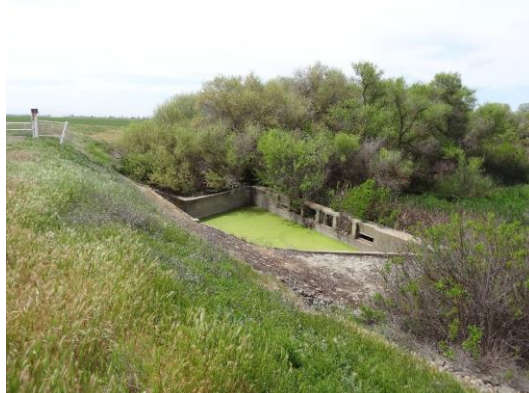
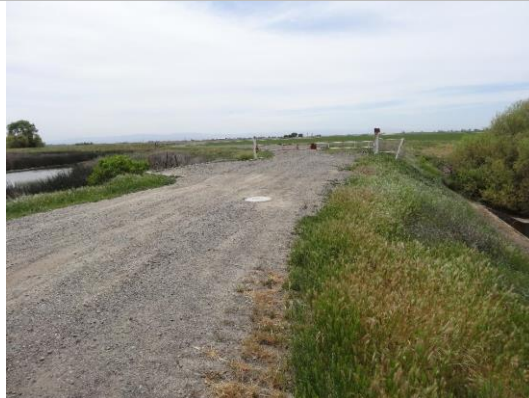
LM Start	0.03	Rating **	M	Issue No.	17
LM End	0.03	Issue Type +	En	Location *	WS
Category	Supplemental			GPS Latitude/Longitude	
				Start	End
Item	DWR UCIP Field Study			37.112353 °	37.112353 °
				-120.589565 °	-120.589565 °
DWR ID					
Comment Code					
Inspector Comment					
FS_ID:40529					
DS_ID:19977					
EP_NO: 5024					
Repair Type: Non-Urgent					
Crossing Status: Found					
UCIP Comments: Slide gates blocked by sediment. Recommend contacting owner to determine status of crossing. Crossing appears to be abandoned.					
FIELD_STRUCT_DESC: [San Joaquin River Diversion Structure] 1 of 4: 72x60-inch R.C.B.C. through the levee, 21.0 feet below the crown. Slide gates on the waterward side. Concrete headwalls on both sides. Landward slope cobble revetted. Flashboards can be seen on the downstream side of the structure.					
FS Date: 4/17/2014

View of concrete structure located on landward side.

View of levee crown.

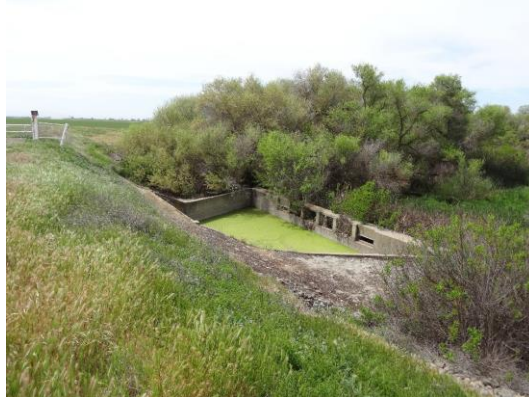
Photo 1 of 2 : UCIP_SP_2016_36875_67308.jpg

LM Start	0.04	Rating **	M	Issue No.	13
LM End	0.04	Issue Type +	En	Location *	WS
Category	Supplemental			GPS Latitude/Longitude	
				Start	End
Item	DWR UCIP Field Study			37.112348 °	37.112348 °
				-120.589581 °	-120.589581 °
DWR ID					
Comment Code					
Inspector Comment					
FS_ID:36875					
DS_ID:24856					
EP_NO: 5024					
Repair Type: Non-Urgent					
Crossing Status: Found					
UCIP Comments: Slide gates blocked by sediment. Recommend contacting owner to determine status of crossing. Crossing appears to be abandoned.					
FIELD_STRUCT_DESC: [San Joaquin River Diversion Structure] 2 of 4: 72x60-inch R.C.B.C. through the levee, 21.0 feet below the crown. Slide gates on the waterward side. Concrete headwalls on both sides. Landward slope cobble revetted. Flashboards can be seen on the downstream side of the structure.					
FS Date: 4/17/2014

View of concrete structure located on landward side.

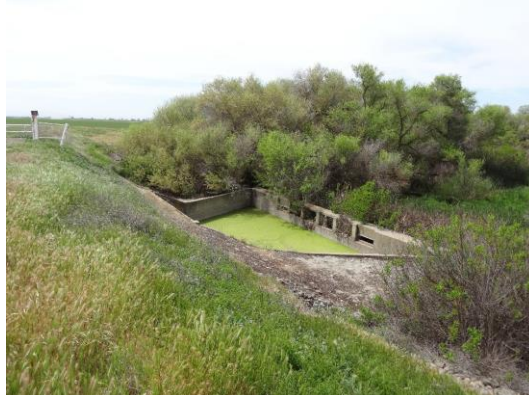
Photo 1 of 2 : UCIP_SP_2016_36877_67328.jpg

LM Start	0.04	Rating **	M	Issue No.	15
LM End	0.04	Issue Type +	En	Location *	WS
Category	Supplemental			GPS Latitude/Longitude	
				Start	End
Item	DWR UCIP Field Study			37.112336 °	37.112336 °
				-120.589624 °	-120.589624 °
DWR ID					
Comment Code					
Inspector Comment					
FS_ID:36877					
DS_ID:24858					
EP_NO: 5024					
Repair Type: Non-Urgent					
Crossing Status: Found					
UCIP Comments: Slide gates blocked by sediment. Recommend contacting owner to determine status of crossing. Crossing appears to be abandoned.					
FIELD_STRUCT_DESC: [San Joaquin River Diversion Structure] 4 of 4: 72x60-inch R.C.B.C. through the levee, 21.0 feet below the crown. Slide gates on the waterward side. Concrete headwalls on both sides. Landward slope cobble revetted. Flashboards can be seen on the downstream side of the structure.					
FS Date: 4/17/2014

View of concrete structure located on landward side.

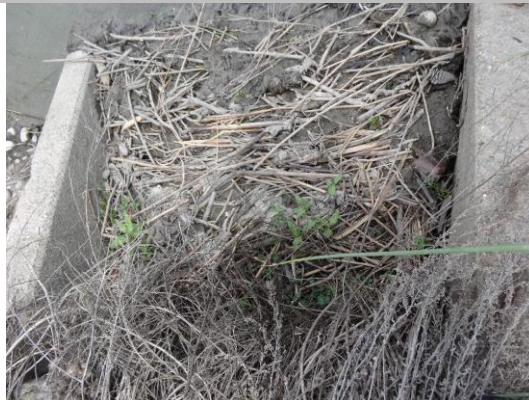
Photo 2 of 2 : UCIP_SP_2016_34093_61981.jpg

Sediment blocking flap gate located on waterward side.

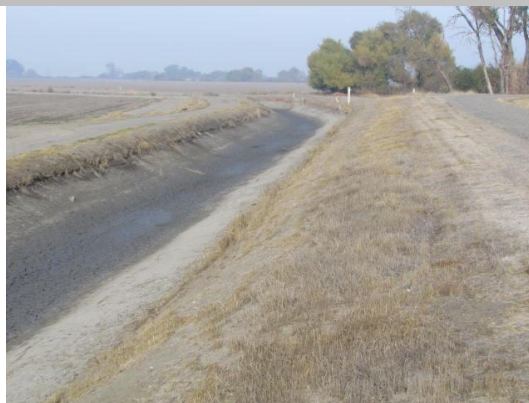
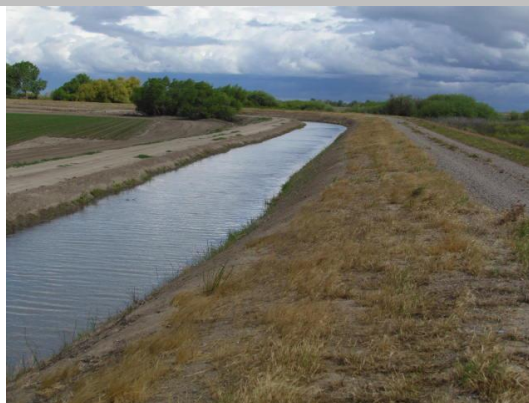
LM Start	0.32	Rating **	M	Issue No.	3 (cont)
LM End	1.41	Issue Type +	En	Location *	LS

Looking north at irrigation ditch at landside toe.

Looking north at irrigation ditch at landward toe. (Fall 2013)

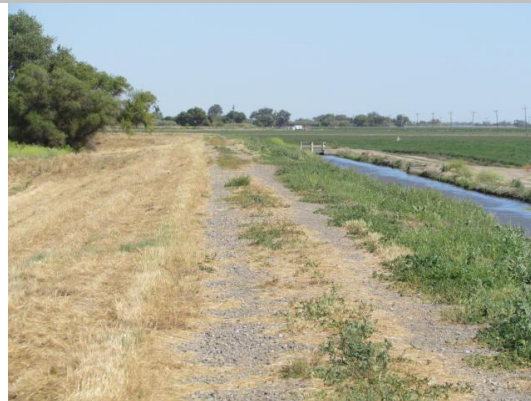
Photo 1 of 1 : SP_2016_NA0010_122_4_20160523_00027.jpg

LM Start	0.54	Rating **	M	Issue No.	4
LM End	1.41	Issue Type +	Ma	Location *	CR
Category	Earthen Levee			GPS Latitude/Longitude	
				Start	End
Item	Vegetation			37.106025 °	37.097556 °
				-120.588746 °	-120.578129 °
DWR ID	DWR_NA0010_04_s_2016_4				
Comment Code					
V1 : Control annual grass and weeds on the levee slopes and easements.					
Inspector Comment					
Control annual weeds on levee crown.

Looking north at levee crown.

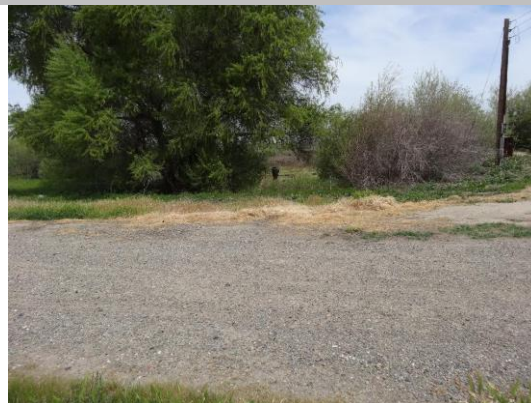
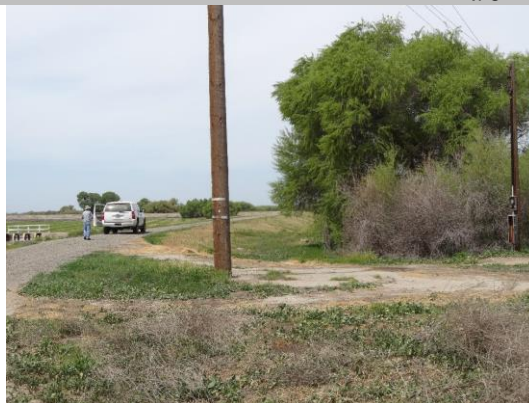
LM Start	1.34	Rating **	M	Issue No.	18
LM End	1.34	Issue Type +	En	Location *	CR
Category	Supplemental			GPS Latitude/Longitude	
				Start	End
Item	DWR UCIP Field Study			37.095274 °	37.095274 °
				-120.577959 °	-120.577959 °
DWR ID					
Comment Code					
Inspector Comment					
FS_ID:40530 DS_ID:19975 EP_NO: 3416 Repair Type: Non-Urgent Crossing Status: Found UCIP Comments: Unable to confirm if crossing is still in use. Need to contact owner to confirm status. FIELD_STRUCT_DESC: 12-inch steel irrigation pipe, encased in 6-inches of reinforced concrete through the levee. Concrete cutoff wall at center of levee. Pumping plant on the waterward bank. Pump and irrigation pipe retained under Permit No. 3416 (1964). FS Date: 4/17/2014

View of waterward side.

Overview of waterward side and levee crown at crossing.

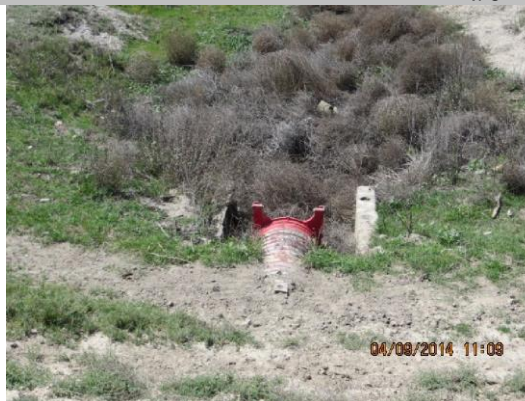
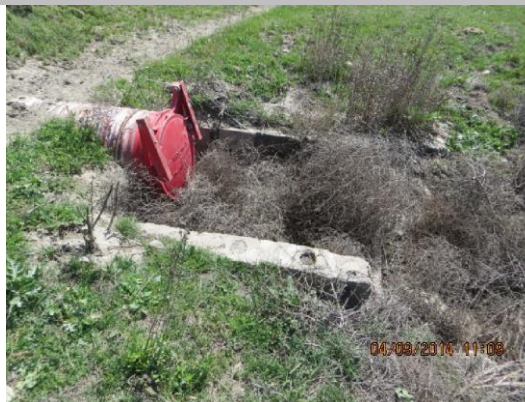
LM Start	0.08	Rating **	M	Issue No.	1326
LM End	0.08	Issue Type +	En	Location *	LS
Category	Supplemental			GPS Latitude/Longitude	
				Start	End
Item	DWR UCIP Field Study			37.278174 °	37.278174 °
				-120.823465 °	-120.823465 °
DWR ID					
Comment Code					
Inspector Comment					
FS_ID:39563 DS_ID:19756 EP_NO: N/A Repair Type: Non-Urgent Crossing Status: Found UCIP Comments: Debris blocking landward headwall--recommend clearing. FIELD_STRUCT_DESC: 24-inch C.M. stormdrain pipe through the levee, 8.6 feet below the crown. Flap gate on the waterward end. Concrete headwall on the landward end. Concrete "U" headwall on the waterward end. (USACE-1967). This entry matches the Drainage or Irrigation Structure referenced in O&M manual (HLM 0.07). FS Date: 4/9/2014

Pipe, flapgate, and concrete headwall on WS toe.

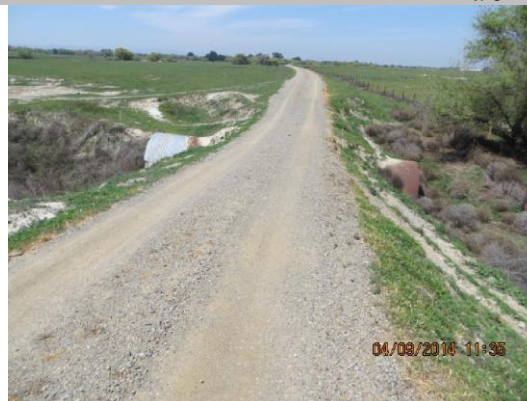
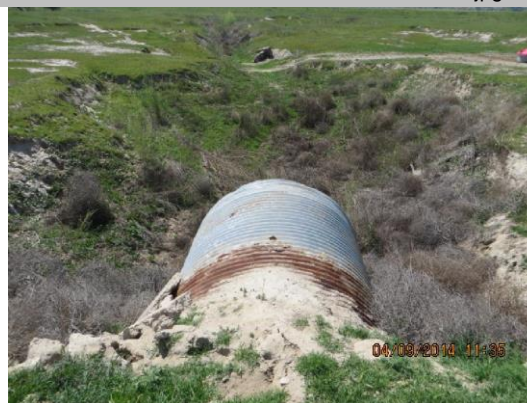
LM Start	0.31	Rating **	U	Issue No.	1334
LM End	0.31	Issue Type +	En	Location *	LS
Category	Supplemental			GPS Latitude/Longitude	
				Start	End
Item	DWR UCIP Field Study			37.276669 °	37.276669 °
				-120.819755 °	-120.819755 °
DWR ID					
Comment Code					
Inspector Comment					
FS_ID:39315 DS_ID:24867 EP_NO: N/A Repair Type: Urgent Crossing Status: Found UCIP Comments: Pipe is open on both ends and levee has been degraded at this location. No permit identified for this crossing. FIELD_STRUCT_DESC: 6'X9' CMP stormdrain through the levee 4.5-feet below the crown. Pipe is CMP on WS toe and Steel on the LS toe. The levee is degraded at this location. FS Date: 4/9/2014

Pipe through levee where levee has been degraded.

Pipe on WS toe.

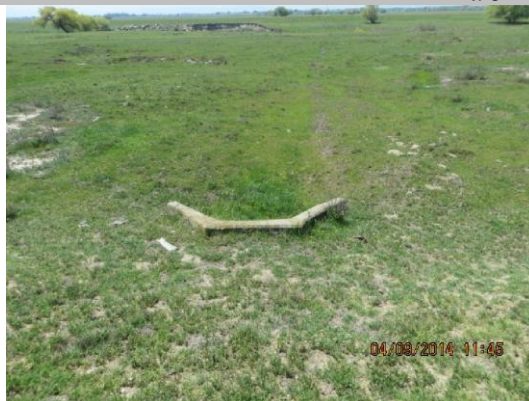
LM Start	0.60	Rating **	M	Issue No.	1327
LM End	0.60	Issue Type +	En	Location *	LS
Category	Supplemental			GPS Latitude/Longitude	
				Start	End
Item	DWR UCIP Field Study			37.273945 °	37.273945 °
				-120.815835 °	-120.815835 °
DWR ID					
Comment Code					
Inspector Comment					
FS_ID:39584 DS_ID:19757 EP_NO: N/A Repair Type: Non-Urgent Crossing Status: Found UCIP Comments: Excess debris on landward headwall--recommend clearing. FIELD_STRUCT_DESC: 30-inch C.M. stormdrain pipe through the levee, 7.5 feet below the crown. Flap gate on the waterward end. Concrete headwall on the landward end. Concrete "U" headwall on the waterward end. (USACE-1967). This entry matches the Drainage or Irrigation Structure referenced in O&M manual (HLM 0.59). FS Date: 4/9/2014

Concrete headwall, pipe, and flapgate on WS toe.

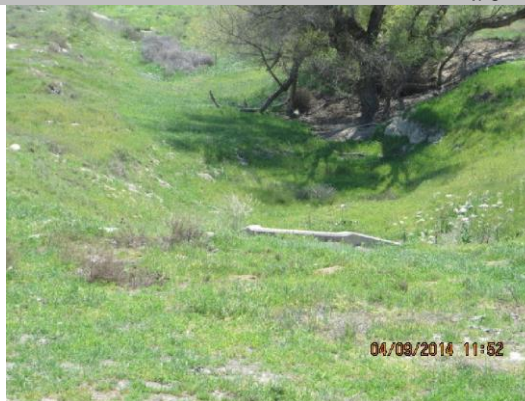
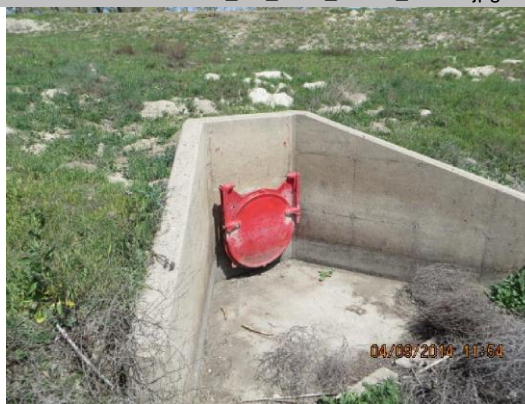
Comment Code					
Inspector Comment					
FS_ID:39585 DS_ID:19758 EP_NO: N/A Repair Type: Non-Urgent Crossing Status: Found UCIP Comments: Dense vegetation limits the inspector's visibility to identify signs of pipe failure (leaks) along the landward slope. Recommend removing vegetation along pipe alignment to conduct proper inspection of structure. FIELD_STRUCT_DESC: 36-inch C.M. stormdrain pipe through the levee, 13.2 feet below the crown. Flap gate on the waterward end. Concrete headwall on the landward end. Concrete "U" headwall on the waterward end. Cobble revetment around both ends. (USACE-1967). This entry matches the Drainage or Irrigation Structure referenced in O&M manual (HLM 0.65). FS Date: 4/9/2014

Concrete headwall visible off WS toe.

Pipe, flapgate, and headwall at WS toe.

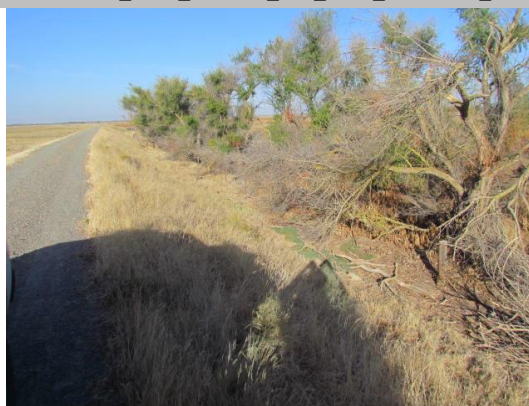
Photo 1 of 1 : SP_2016_NA0010_123_1308_20160512_00011.jpg

LM Start	2.82	Rating **	M	Issue No.	1308
LM End	2.82	Issue Type +	Ma	Location *	LS
Category	Earthen Levee			GPS Latitude/Longitude	
				Start	End
Item	Encroachments			37.256783 °	37.256783 °
				-120.785438 °	-120.785438 °
DWR ID	DWR_NA0010_05_s_2015_1308				
Comment Code					
TR : Tree or limb					
Inspector Comment					
Dead tree limbs at landward toe.

Looking at dead tree limbs on landward toe.

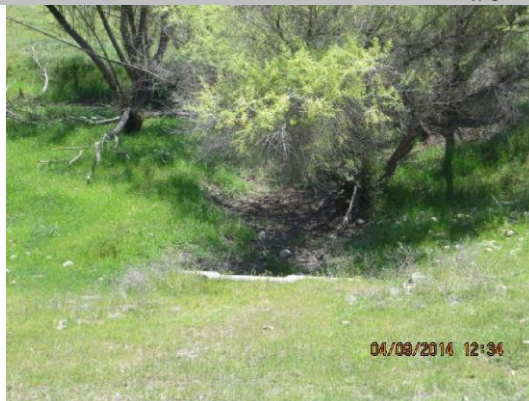
Photo 1 of 2 : UCIP_SP_2016_33709_60943.jpg

LM Start	2.84	Rating **	M	Issue No.	1319
LM End	2.84	Issue Type +	En	Location *	LS
Category	Supplemental			GPS Latitude/Longitude	
				Start	End
Item	DWR UCIP Field Study			37.256810 °	37.256810 °
				-120.785113 °	-120.785113 °
DWR ID					
Comment Code					
Inspector Comment					
FS_ID:33709					
DS_ID:19809					
EP_NO: N/A					
Repair Type: Non-Urgent					
Crossing Status: Found					
UCIP Comments: Log partially blocking inlet at LS toe.					
FIELD_STRUCT_DESC: 24-inch C.M. stormdrain pipe through the					
levee, 15.0 feet below the crown. Flap gate on the waterward end.					
Concrete "U" headwalls on both ends. (USACE-1967). This entry					
matches the Drainage or Irrigation Structure referenced in O&M manual					
(HLM 2.85).					
FS Date: 4/9/2014

Concrete headwall at outlet on WS toe.

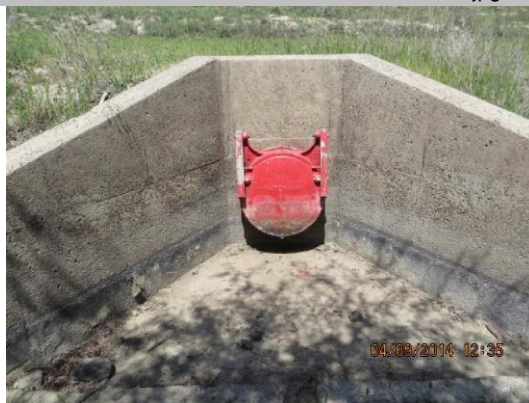
Photo 2 of 2 : UCIP_SP_2016_33709_60941.jpg

LM Start	2.84	Rating **	M	Issue No.	1319 (cont)
LM End	2.84	Issue Type +	En	Location *	LS

Headwall, pipe, and flapgate on WS toe.

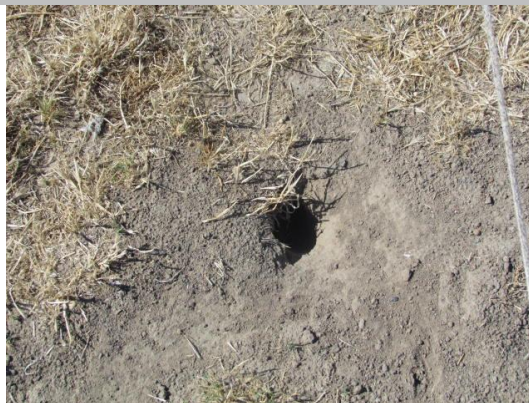
Photo 1 of 1 : SP_2016_NA0010_123_6_20160512_00003.jpg

LM Start	3.20	Rating **	M	Issue No.	6
LM End	3.20	Issue Type +	Ma	Location *	WS
Category	Earthen Levee			GPS Latitude/Longitude	
				Start	End
Item	Animal Control			37.256635 °	37.256635 °
				-120.778935 °	-120.778935 °
DWR ID	DWR_NA0010_05_s_2014_6				
Comment Code					
A1 : Exterminate rodents and backfill and compact or grout burrows.					
Inspector Comment					
No rodent visible but several rodent holes visible.

Looking at typical view of rodent holes on waterward slope.

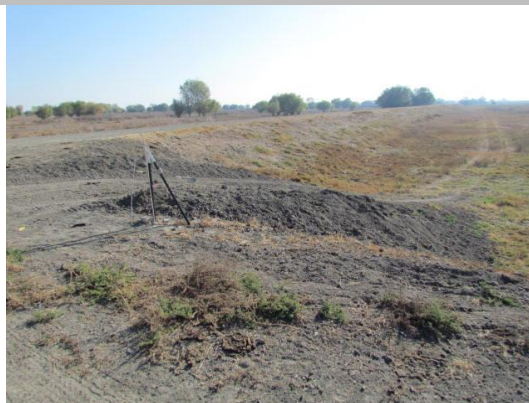
Photo 1 of 3 : SP_2016_NA0010_123_7_20160512_00004.jpg

LM Start	3.20	Rating **	M	Issue No.	7
LM End	3.20	Issue Type +	En	Location *	WS
Category	Earthen Levee			GPS Latitude/Longitude	
				Start	End
Item	Encroachments			37.256554 °	37.256554 °
				-120.778847 °	-120.778847 °
DWR ID	DWR_NA0010_05_f_2012_7				
Comment Code					
RA : Ramp					
Inspector Comment					
Unauthorized ramp on waterside slope.

Looking south at unauthorized ramp on waterside slope.

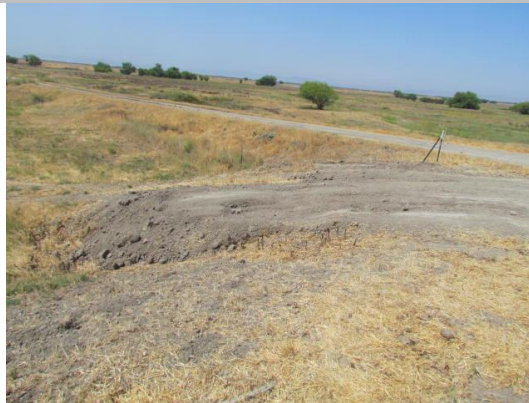
Photo 2 of 3 : SP_2016_NA0010_123_7_20160512_00005.jpg

LM Start	3.20	Rating **	M	Issue No.	7 (cont)
LM End	3.20	Issue Type +	En	Location *	WS

Looking northwest at unauthorized ramp on waterward slope.

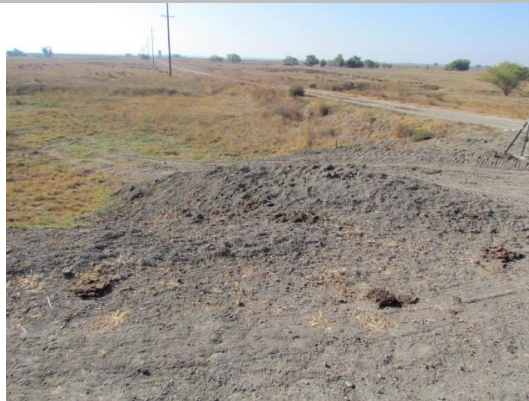
Photo 3 of 3 : SP_2016_NA0010_123_7_20160512_00006.jpg

LM Start	3.20	Rating **	M	Issue No.	7 (cont)	
LM End	3.20	Issue Type +	En	Location *	WS	
Category	Earthen Levee			GPS Latitude/Longitude		
				Start		End
Item	Encroachments			37.256554 °		37.256554 °
				-120.778847 °		-120.778847 °
DWR ID	DWR_NA0010_05_f_2012_7					
Comment Code						
RA : Ramp						
Inspector Comment						
Unauthorized ramp on waterside slope.

Looking northwest at unauthorized ramp on waterside slope.

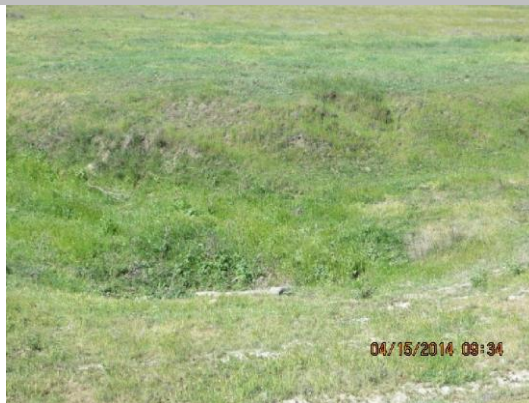
Photo 1 of 2 : UCIP_SP_2016_43055_60948.jpg

LM Start	3.34	Rating **	M	Issue No.	1337
LM End	3.34	Issue Type +	En	Location *	WS
Category	Supplemental			GPS Latitude/Longitude	
				Start	End
Item	DWR UCIP Field Study			37.255258 °	37.255258 °
				-120.776996 °	-120.776996 °
DWR ID					
Comment Code					
Inspector Comment					
FS_ID:43055 DS_ID:19810 EP_NO: N/A Repair Type: Non-Urgent Crossing Status: Found UCIP Comments: Pipe corroded through at flapgate on WS toe. FIELD_STRUCT_DESC: 24-inch C.M. stormdrain pipe through the levee, 14.7 feet below the crown. Flap gate on the waterward end. Concrete "U" headwalls on both ends. (USACE-1967). This entry matches the Drainage or Irrigation Structure referenced in O&M manual (HLM 3.33). FS Date: 4/15/2014

Concrete headwall at WS toe.

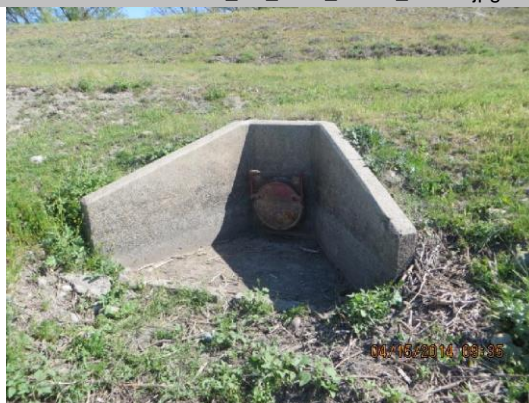
Photo 2 of 2 : UCIP_SP_2016_43055_60946.jpg

LM Start	3.34	Rating **	M	Issue No.	1337 (cont)
LM End	3.34	Issue Type +	En	Location *	WS
Category	Supplemental			GPS Latitude/Longitude	
				Start	End
Item	DWR UCIP Field Study			37.255258 °	37.255258 °
				-120.776996 °	-120.776996 °
DWR ID					
Comment Code					
Inspector Comment					
FS_ID:43055 DS_ID:19810 EP_NO: N/A Repair Type: Non-Urgent Crossing Status: Found UCIP Comments: Pipe corroded through at flapgate on WS toe. FIELD_STRUCT_DESC: 24-inch C.M. stormdrain pipe through the levee, 14.7 feet below the crown. Flap gate on the waterward end. Concrete "U" headwalls on both ends. (USACE-1967). This entry matches the Drainage or Irrigation Structure referenced in O&M manual (HLM 3.33). FS Date: 4/15/2014

Flapgate and Concrete headwall at WS toe.

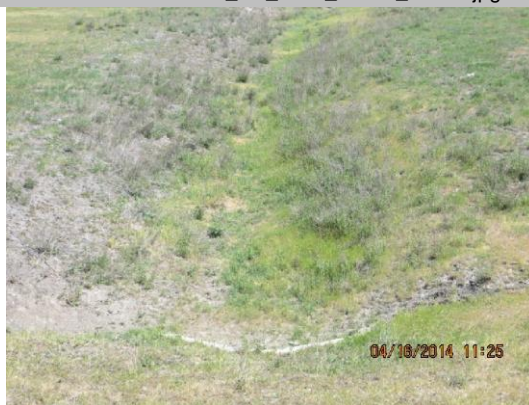
Photo 1 of 2 : UCIP_SP_2016_39586_61137.jpg

LM Start	3.68	Rating **	M	Issue No.	1329
LM End	3.68	Issue Type +	En	Location *	WS
Category	Supplemental			GPS Latitude/Longitude	
				Start	End
Item	DWR UCIP Field Study			37.252308 °	37.252308 °
				-120.768038 °	-120.768038 °
DWR ID					
Comment Code					
Inspector Comment					
FS_ID:39586 DS_ID:19811 EP_NO: N/A Repair Type: Non-Urgent Crossing Status: Found UCIP Comments: Sediment buildup in pipe visible from landward side-- recommend contacting owner to clear pipe. FIELD_STRUCT_DESC: 24-inch C.M. stormdrain pipe through the levee, 15.0 feet below the crown. Flap gate on the waterward end. Concrete headwall on the landward end. Concrete "U" headwall on the waterward end. (USACE-1967). This entry matches the Drainage or Irrigation Structure referenced in O&M manual (HLM 3.67). FS Date: 4/16/2014

Pipe, headwall, and flapgate on WS toe.

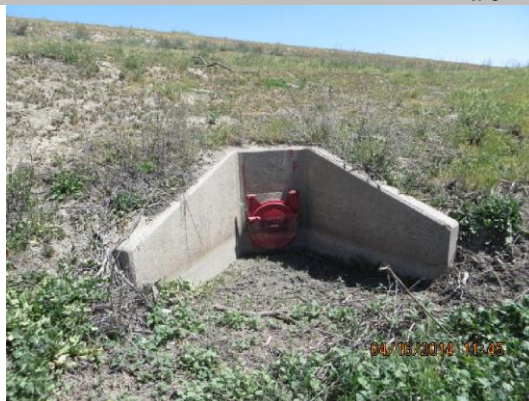
Photo 2 of 2 : UCIP_SP_2016_39880_61143.jpg

LM Start	4.02	Rating **	M	Issue No.	1338 (cont)
LM End	4.02	Issue Type +	En	Location *	WS
Category	Supplemental			GPS Latitude/Longitude	
				Start	End
Item	DWR UCIP Field Study			37.248432 °	37.248432 °
				-120.764066 °	-120.764066 °
DWR ID					
Comment Code					
Inspector Comment					
FS_ID:39880 DS_ID:19769 EP_NO: N/A Repair Type: Non-Urgent Crossing Status: Found UCIP Comments: Sediment buildup in pipe visible from landward side--recommend contacting owner to clear pipe. FIELD_STRUCT_DESC: 24-inch C.M. stormdrain pipe through the levee, 16.0 feet below the crown. Flap gate on the waterward end. Concrete "U" headwalls on both ends. (USACE-1967). This entry matches the Drainage or Irrigation Structure referenced in O&M manual (HLM 4.02). FS Date: 4/16/2014

Pipe, headwall, and flapgate on WS toe.

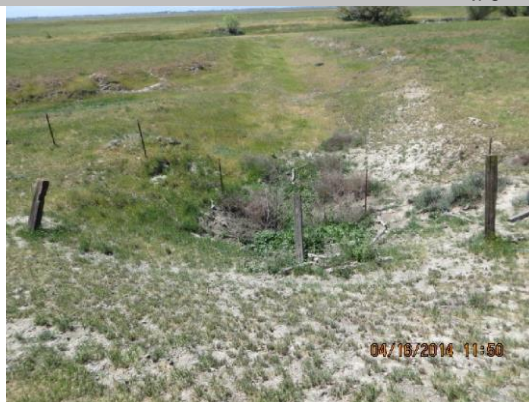
Photo 1 of 2 : UCIP_SP_2016_39588_61146.jpg

LM Start	4.27	Rating **	M	Issue No.	1330
LM End	4.27	Issue Type +	En	Location *	WS
Category	Supplemental			GPS Latitude/Longitude	
				Start	End
Item	DWR UCIP Field Study			37.246008 °	37.246008 °
				-120.760706 °	-120.760706 °
DWR ID					
Comment Code					
Inspector Comment					
FS_ID:39588 DS_ID:19770 EP_NO: N/A Repair Type: Non-Urgent Crossing Status: Found UCIP Comments: Sediment buildup in pipe visible from landward side--recommend contacting owner to clear pipe. FIELD_STRUCT_DESC: 24-inch C.M. stormdrain pipe through the levee, 11.6-feet below the crown. Flap gate on the waterward end. Concrete head wall on the landward end. Concrete "U" headwall on the waterward end. (USACE-1967). This entry matches the Drainage or Irrigation Structure referenced in O&M manual (HLM 4.27). FS Date: 4/16/2014

Pipe, headwall, and flapgate on WS toe.

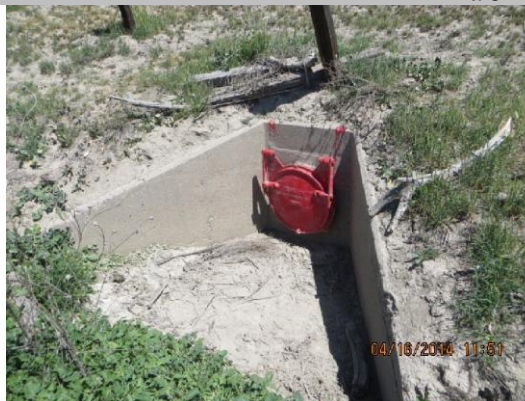
Photo 2 of 2 : UCIP_SP_2016_39588_61145.jpg

LM Start	4.27	Rating **	M	Issue No.	1330 (cont)
LM End	4.27	Issue Type +	En	Location *	WS
Category	Supplemental			GPS Latitude/Longitude	
				Start	End
Item	DWR UCIP Field Study			37.246008 °	37.246008 °
				-120.760706 °	-120.760706 °
DWR ID					
Comment Code					
Inspector Comment					
FS_ID:39588 DS_ID:19770 EP_NO: N/A Repair Type: Non-Urgent Crossing Status: Found UCIP Comments: Sediment buildup in pipe visible from landward side--recommend contacting owner to clear pipe. FIELD_STRUCT_DESC: 24-inch C.M. stormdrain pipe through the levee, 11.6-feet below the crown. Flap gate on the waterward end. Concrete head wall on the landward end. Concrete "U" headwall on the waterward end. (USACE-1967). This entry matches the Drainage or Irrigation Structure referenced in O&M manual (HLM 4.27). FS Date: 4/16/2014

Pipe, headwall, and flapgate on WS toe.

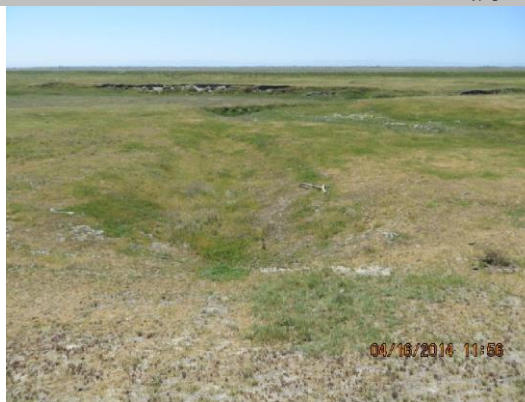
Photo 1 of 2 : UCIP_SP_2016_39589_62081.jpg

LM Start	4.55	Rating **	M	Issue No.	1331
LM End	4.55	Issue Type +	En	Location *	WS
Category	Supplemental			GPS Latitude/Longitude	
				Start	End
Item	DWR UCIP Field Study			37.243668 °	37.243668 °
				-120.756812 °	-120.756812 °
DWR ID					
Comment Code					
Inspector Comment					
FS_ID:39589 DS_ID:19771 EP_NO: N/A Repair Type: Non-Urgent Crossing Status: Found UCIP Comments: Sediment buildup in pipe visible from landward side--recommend contacting owner to clear pipe. FIELD_STRUCT_DESC: 24-inch C.M. stormdrain pipe through the levee, 12.0-feet below the crown. Flap gate on the waterward end. Concrete headwall on the landward end. Concrete "U" headwall on the waterward end. (USACE-1967). This entry matches the Drainage or Irrigation Structure referenced in O&M manual (HLM 4.54). FS Date: 4/16/2014 8:16:00 AM

Pipe, flapgate, and headwall on WS toe.

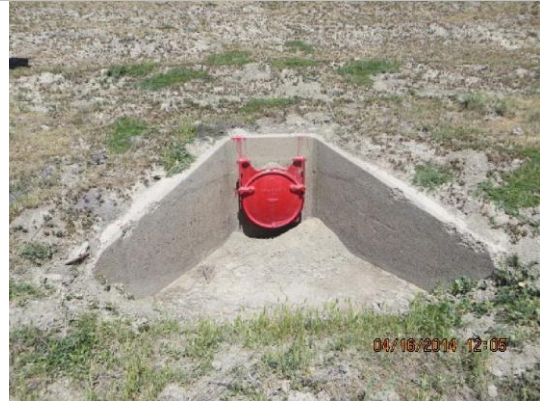
Photo 2 of 2 : UCIP_SP_2016_39590_62088.jpg

LM Start	4.89	Rating **	M	Issue No.	1332 (cont)
LM End	4.89	Issue Type +	En	Location *	WS
Category	Supplemental			GPS Latitude/Longitude	
				Start	End
Item	DWR UCIP Field Study			37.240978 °	37.240978 °
				-120.751613 °	-120.751613 °
DWR ID					
Comment Code					
Inspector Comment					
FS_ID:39590 DS_ID:19772 EP_NO: N/A Repair Type: Non-Urgent Crossing Status: Found UCIP Comments: Heavy sediment buildup in pipe visible from landward side--recommend contacting owner to clear pipe. FIELD_STRUCT_DESC: 24-inch C.M. stormdrain pipe through the levee, 12.3-feet below the crown. Flap gate on the waterward end. Concrete headwall on the landward end. Concrete "U" headwall on the waterward end. (USACE-1967). This entry matches the Drainage or Irrigation Structure referenced in O&M manual (HLM 4.89). FS Date: 4/16/2014

Headwall, flapgate, and pipe on WS toe.

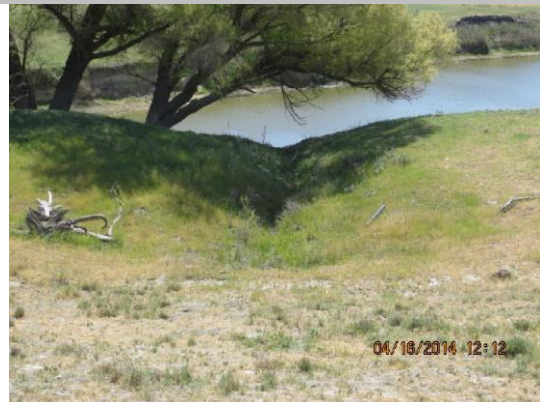
Photo 1 of 2 : UCIP_SP_2016_39591_62091.jpg

LM Start	5.15	Rating **	M	Issue No.	1333
LM End	5.15	Issue Type +	En	Location *	WS
Category	Supplemental			GPS Latitude/Longitude	
				Start	End
Item	DWR UCIP Field Study			37.240607 °	37.240607 °
				-120.746916 °	-120.746916 °
DWR ID					
Comment Code					
Inspector Comment					
FS_ID:39591 DS_ID:19773 EP_NO: N/A Repair Type: Non-Urgent Crossing Status: Found UCIP Comments: Heavy sediment buildup in pipe visible from landward side--recommend contacting owner to clear pipe. FIELD_STRUCT_DESC: 24-inch C.M. stormdrain pipe through the levee, 12.2-feet below the crown. Flap gate on the waterward end. Concrete headwall on the landward end. Concrete "U" headwall on the waterward end. (USACE-1967). This entry matches the Drainage or Irrigation Structure referenced in O&M manual (HLM 5.15). FS Date: 4/16/2014

Headwall, flapgate, and pipe on WS toe.

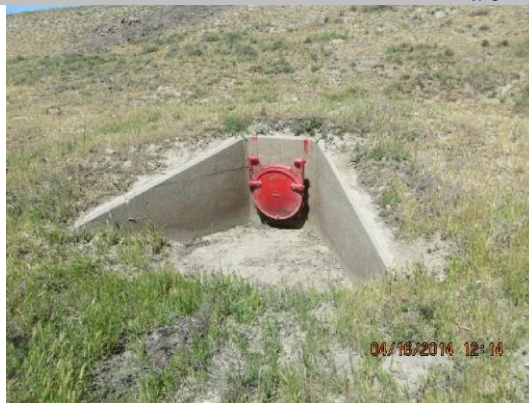
Photo 2 of 2 : UCIP_SP_2016_39591_62093.jpg

LM Start	5.15	Rating **	M	Issue No.	1333 (cont)	
LM End	5.15	Issue Type +	En	Location *	WS	
Category	Supplemental			GPS Latitude/Longitude		
				Start		End
Item	DWR UCIP Field Study			37.240607 °		37.240607 °
				-120.746916 °		-120.746916 °
DWR ID						
Comment Code						
Inspector Comment						
FS_ID:39591 DS_ID:19773 EP_NO: N/A Repair Type: Non-Urgent Crossing Status: Found UCIP Comments: Heavy sediment buildup in pipe visible from landward side--recommend contacting owner to clear pipe. FIELD_STRUCT_DESC: 24-inch C.M. stormdrain pipe through the levee, 12.2-feet below the crown. Flap gate on the waterward end. Concrete headwall on the landward end. Concrete "U" headwall on the waterward end. (USACE-1967). This entry matches the Drainage or Irrigation Structure referenced in O&M manual (HLM 5.15). FS Date: 4/16/2014

Headwall, flapgate, and pipe on WS toe.

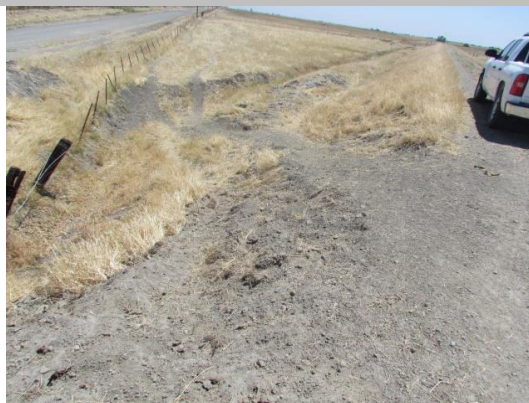
Photo 2 of 2 : SP_2016_NA0010_123_1309_20160512_00013.jpg

LM Start	6.59	Rating **	M	Issue No.	1309
LM End	6.59	Issue Type +	Ma	Location *	LS
Category	Earthen Levee			GPS Latitude/Longitude	
				Start	End
Item	Slope Stability			37.229682 °	37.229682 °
				-120.726305 °	-120.726305 °
DWR ID	DWR_NA0010_05_s _ 2015_1309				
Comment Code					
S2 : Repair the levee slope damaged by foot traffic and prevent access where possible.					
Inspector Comment					
Landward slope damage caused by animal foot traffic.

Looking east at damaged landward slope.

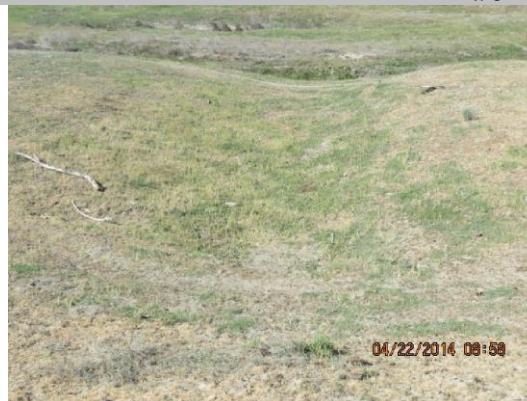
Photo 1 of 2 : UCIP_SP_2016_39592_62111.jpg

LM Start	7.36	Rating **	M	Issue No.	1350
LM End	7.36	Issue Type +	En	Location *	LS
Category	Supplemental			GPS Latitude/Longitude	
				Start	End
Item	DWR UCIP Field Study			37.224560 °	37.224560 °
				-120.714057 °	-120.714057 °
DWR ID					
Comment Code					
Inspector Comment					
FS_ID:39592 DS_ID:19761 EP_NO: N/A Repair Type: Non-Urgent Crossing Status: Found UCIP Comments: Sediment buildup in pipe visible from landward side--recommend contacting owner to clear pipe. FIELD_STRUCT_DESC: 24-inch C.M. stormdrain pipe through the levee, 12.0-feet below the crown. Flap gate on the waterward end. Concrete headwall on the landward end. Concrete "U" headwall on the waterward end. (USACE-1967). This entry matches the Drainage or Irrigation Structure referenced in O&M manual (HLM 7.36). FS Date: 4/22/2014

Headwall, flapgate, and pipe on WS toe.

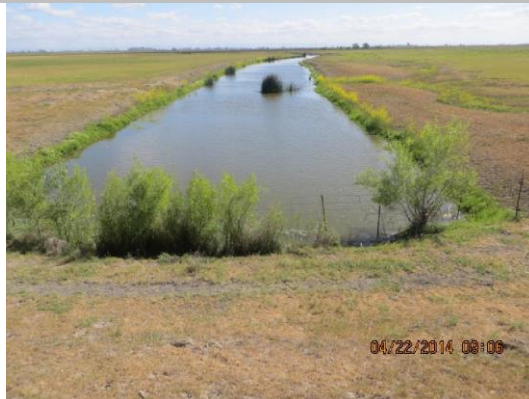
Photo 1 of 2 : UCIP_SP_2016_34170_62116.jpg

LM Start	7.58	Rating **	M	Issue No.	1316
LM End	7.58	Issue Type +	En	Location *	LS
Category	Supplemental			GPS Latitude/Longitude	
				Start	End
Item	DWR UCIP Field Study			37.221465 °	37.221465 °
				-120.713780 °	-120.713780 °
DWR ID					
Comment Code					
Inspector Comment					
FS_ID:34170 DS_ID:19762 EP_NO: N/A Repair Type: Non-Urgent Crossing Status: Indicator Found UCIP Comments: Appears abandoned and if so should be done so properly. Slide gate rusted shut on WS slope. Unable to locate inlet or outlet. FIELD_STRUCT_DESC: 24-inch C.M. stormdrain pipe through the levee, 20.4 feet below the crown. Slide gate in 36-inch C.M. pipe riser unit in waterward slope. Concrete "U" headwalls on each end (not found 2014). (USACE-1967). This entry matches the Drainage or Irrigation Structure referenced in O&M manual (HLM 7.58). FS Date: 4/22/2014

Likely inlet on LS toe. No pipe or headwall can be seen at current water level.

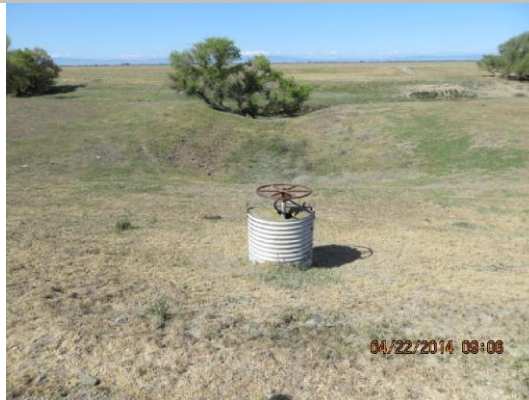
Photo 2 of 2 : UCIP_SP_2016_34170_62115.jpg

Slide gate in CMP riser on WS slope. No outlet or pipe found on WS toe.

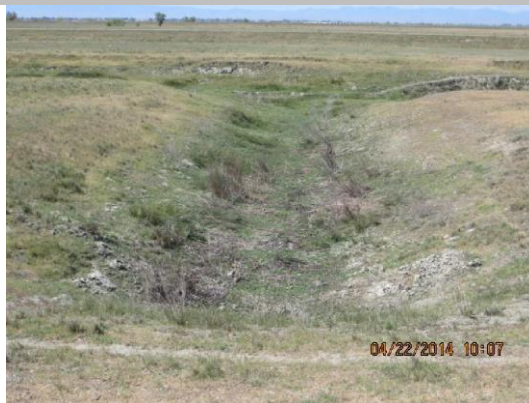
Photo 1 of 2 : UCIP_SP_2016_34265_62182.jpg

LM Start	8.46	Rating **	M	Issue No.	1317
LM End	8.46	Issue Type +	En	Location *	LS
Category	Supplemental			GPS Latitude/Longitude	
				Start	End
Item	DWR UCIP Field Study			37.209606 °	37.209606 °
				-120.702069 °	-120.702069 °
DWR ID					
Comment Code					
Inspector Comment					
FS_ID:34265 DS_ID:19763 EP_NO: N/A Repair Type: Non-Urgent Crossing Status: Found UCIP Comments: Pipe filled with silt on LS toe and should be cleared. FIELD_STRUCT_DESC: 24-inch CM stormdrain pipe through the levee, 16.0-feet below the crown. Flap gate on the waterward end. Concrete headwall on the landward end. Concrete "U" headwalls on the waterward end. (USACE-1967). This entry matches the Drainage or Irrigation Structure referenced in O&M manual (HLM 8.44). FS Date: 4/22/2014

Headwall, flapgate, and pipe on WS toe

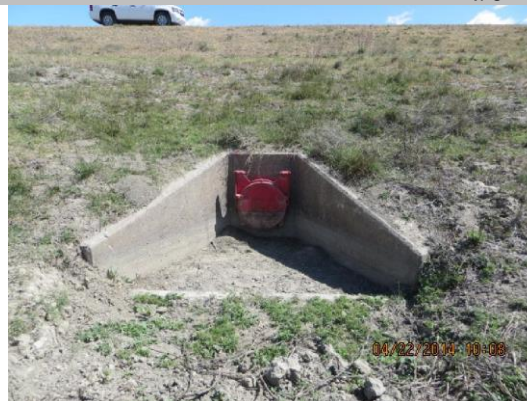
Photo 2 of 2 : UCIP_SP_2016_34265_62183.jpg

LM Start	8.46	Rating **	M	Issue No.	1317 (cont)	
LM End	8.46	Issue Type +	En	Location *	LS	
Category	Supplemental			GPS Latitude/Longitude		
				Start	End	
Item	DWR UCIP Field Study			37.209606 °	37.209606 °	
				-120.702069 °	-120.702069 °	
DWR ID						
Comment Code						
Inspector Comment						
FS_ID:34265						
DS_ID:19763						
EP_NO: N/A						
Repair Type: Non-Urgent						
Crossing Status: Found						
UCIP Comments: Pipe filled with silt on LS toe and should be cleared.						
FIELD_STRUCT_DESC: 24-inch CM stormdrain pipe through the levee,						
16.0-feet below the crown. Flap gate on the waterward end. Concrete						
headwall on the landward end. Concrete "U" headwalls on the						
waterward end. (USACE-1967). This entry matches the Drainage or						
Irrigation Structure referenced in O&M manual (HLM 8.44).						
FS Date: 4/22/2014

Headwall, flapgate, and pipe on WS toe

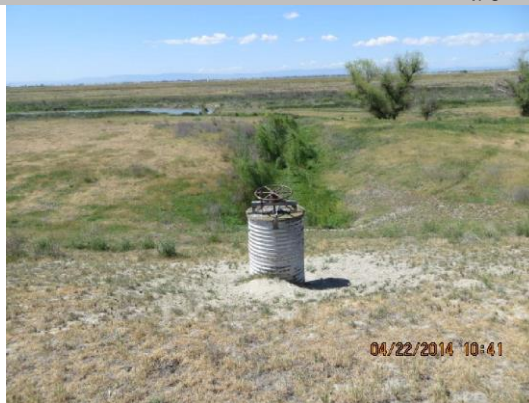
Photo 1 of 2 : UCIP_SP_2016_34273_62201.jpg

LM Start	10.06	Rating **	M	Issue No.	1318
LM End	10.06	Issue Type +	En	Location *	WS
Category	Supplemental			GPS Latitude/Longitude	
				Start	End
Item	DWR UCIP Field Study			37.194736 °	37.194736 °
				-120.680116 °	-120.680116 °
DWR ID					
Comment Code					
Inspector Comment					
FS_ID:34273 DS_ID:19767 EP_NO: N/A Repair Type: Non-Urgent Crossing Status: Found UCIP Comments: Slidegate actuator appears bent and may not work properly (WS slope). FIELD_STRUCT_DESC: 24-inch CM stormdrain pipe through the levee, 15.0-feet below the crown. Slide gate in 36-inch CM pipe riser on the waterward slope. Concrete headwall on both ends. (USACE-1967). This entry matches the Drainage or Irrigation Structure referenced in O&M manual (HLM 10.05). FS Date: 4/22/2014

Slidegate in CMP riser on WS slope.

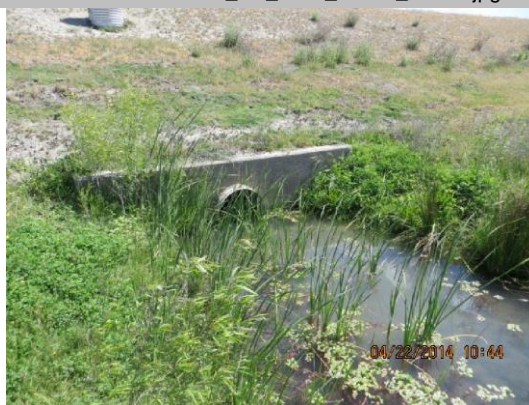
Photo 2 of 2 : UCIP_SP_2016_34273_62202.jpg

Concrete headwall and pipe on WS toe.

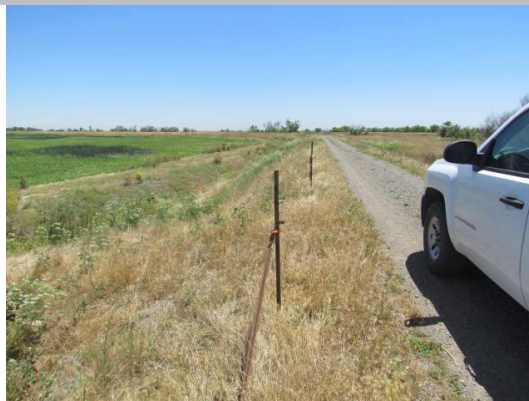
Photo 1 of 1 : SP_2016_NA0010_123_1_20160523_00206.jpg

LM Start	12.24	Rating **	M	Issue No.	1
LM End	13.76	Issue Type +	En	Location *	LS
Category	Earthen Levee			GPS Latitude/Longitude	
				Start	End
Item	Encroachments			37.177715 °	37.167788 °
				-120.651339 °	-120.629446 °
DWR ID	DWR_NA0010_05_s_2016_1				
Comment Code					
FE : Fence					
Inspector Comment					
T-poles and Electric fence on landward slope and shoulder should be removed.

Looking south on landward shoulder T-poles and electric fence.

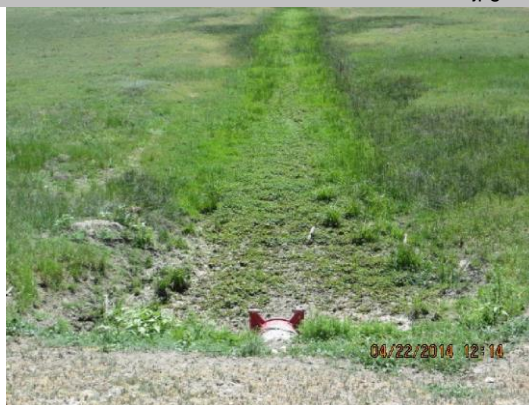
Photo 1 of 2 : UCIP_SP_2016_39593_62240.jpg

LM Start	12.89	Rating **	M	Issue No.	1351
LM End	12.89	Issue Type +	En	Location *	LS
Category	Supplemental			GPS Latitude/Longitude	
				Start	End
Item	DWR UCIP Field Study			37.175816 °	37.175816 °
				-120.640865 °	-120.640865 °
DWR ID					
Comment Code					
Inspector Comment					
FS_ID:39593 DS_ID:19707 EP_NO: N/A Repair Type: Non-Urgent Crossing Status: Found UCIP Comments: Sediment buildup in pipe visible from landward side--recommend contacting owner to clear pipe. FIELD_STRUCT_DESC: 24-inch CM stormdrain pipe through the levee, 10.2-feet below the crown. Flap gate on the waterward end. Concrete headwalls on the landward end with flashboards. Concrete saddle and apron on the waterward end with a flapgate. Metal screen at LS toe inlet (USACE-1967). This entry matches the Drainage or Irrigation Structure referenced in O&M manual (HLM 12.87). FS Date: 4/22/2014

Headwall, flapgate, and pipe on WS toe.

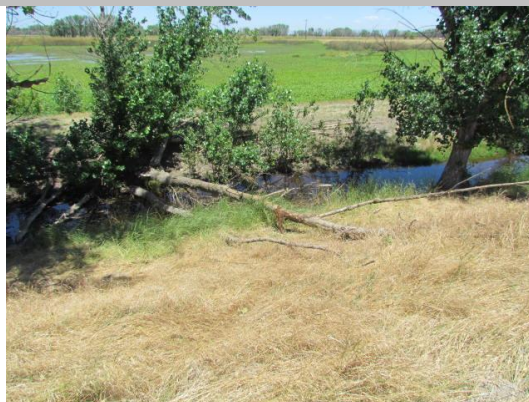
Photo 1 of 1 : SP_2016_NA0010_123_2_20160523_00207.jpg

LM Start	13.01	Rating **	M	Issue No.	2
LM End	13.01	Issue Type +	Ma	Location *	LS
Category	Earthen Levee			GPS Latitude/Longitude	
				Start	End
Item	Encroachments			37.175576 °	37.175576 °
				-120.638755 °	-120.638755 °
DWR ID	DWR_NA0010_05_s_2016_2				
Comment Code					
TR : Tree or limb					
Inspector Comment					
Downed tree on landward toe.

Looking west at down tree at landward toe.

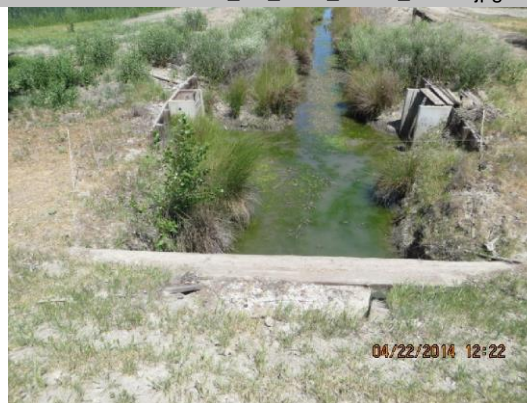
Photo 1 of 2 : UCIP_SP_2016_34288_62244.jpg

LM Start	13.42	Rating **	M	Issue No.	1321
LM End	13.42	Issue Type +	En	Location *	LS
Category	Supplemental			GPS Latitude/Longitude	
				Start	End
Item	DWR UCIP Field Study			37.171523 °	37.171523 °
				-120.633442 °	-120.633442 °
DWR ID					
Comment Code					
Inspector Comment					
FS_ID:34288 DS_ID:19708 EP_NO: N/A Repair Type: Non-Urgent Crossing Status: Found UCIP Comments: Some erosion around headwall on the WS toe and there are animal burrows on both slopes. FIELD_STRUCT_DESC: 48-inch C.M. stormdrain pipe through the levee, 10.0-feet below the crown. Flap gate on the waterward end. Flashboard attachment in concrete "U" headwall on the landward end. Concrete "U" headwall on the waterward end. (USACE-1967). This entry matches the Drainage or Irrigation Structure referenced in O&M manual (HLM 13.40). FS Date: 4/22/2014

Headwall and pipe on LS toe.

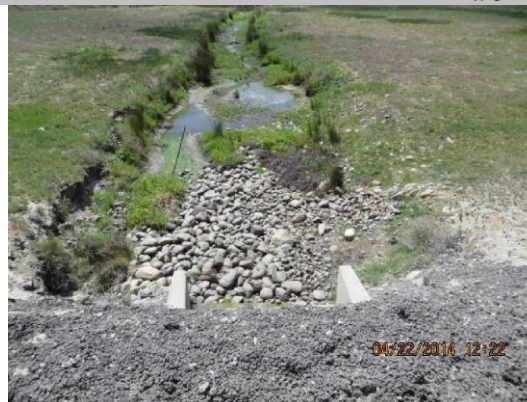
Photo 2 of 2 : UCIP_SP_2016_34288_62243.jpg

Headwall, flapgate, and pipe on WS toe.

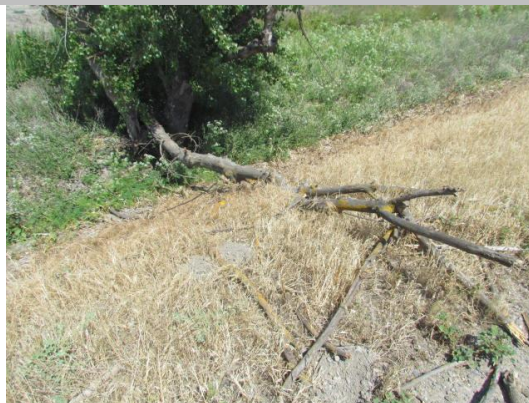
Photo 1 of 1 : SP_2016_NA0010_123_1311_20160512_00015.jpg

LM Start	13.59	Rating **	M	Issue No.	1311
LM End	13.59	Issue Type +	Ma	Location *	LS
Category	Earthen Levee			GPS Latitude/Longitude	
				Start	End
Item	Encroachments			37.169607 °	37.169607 °
				-120.631358 °	-120.631358 °
DWR ID	DWR_NA0010_05_s_2015_1311				
Comment Code					
TR : Tree or limb					
Inspector Comment					
Downed tree on landward slope.

Looking east at a fallen tree limbs on waterward slope.

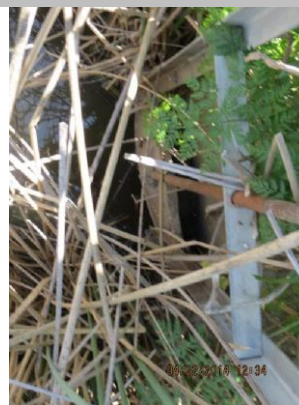
Photo 1 of 2 : UCIP_SP_2016_34824_62624.jpg

LM Start	13.72	Rating **	M	Issue No.	1325
LM End	13.72	Issue Type +	En	Location *	LS
Category	Supplemental			GPS Latitude/Longitude	
				Start	End
Item	DWR UCIP Field Study			37.168202 °	37.168202 °
				-120.629886 °	-120.629886 °
DWR ID					
Comment Code					
Inspector Comment					
FS_ID:34824 DS_ID:19709 EP_NO: N/A Repair Type: Non-Urgent Crossing Status: Found UCIP Comments: Pipe not visible and may need to have silt removed from outlet on WS toe. FIELD_STRUCT_DESC: 24-inch C.M. stormdrain pipe through the levee, 16-feet below the crown. Flap gate on the waterward end. Slidegate on concrete headwall at LS toe. Concrete saddle and apron on the waterward end. (USACE-1967). This entry matches the Drainage or Irrigation Structure referenced in O&M manual (HLM 13.72). FS Date: 4/22/2014

Slide gate at concrete headwall on LS toe.

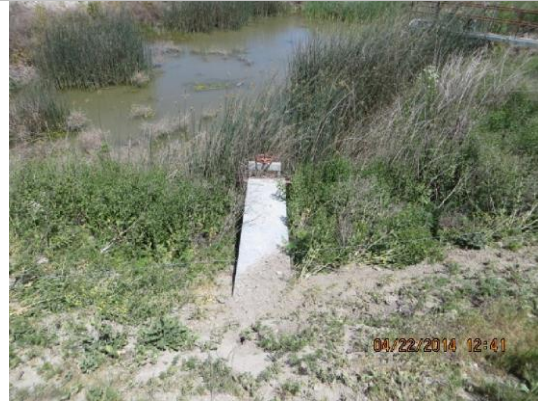
Photo 2 of 2 : UCIP_SP_2016_34824_62623.jpg

LM Start	13.72	Rating **	M	Issue No.	1325 (cont)
LM End	13.72	Issue Type +	En	Location *	LS
Category	Supplemental			GPS Latitude/Longitude	
				Start	End
Item	DWR UCIP Field Study			37.168202°	37.168202°
				-120.629886°	-120.629886°
DWR ID					
Comment Code					
Inspector Comment					
FS_ID:34824 DS_ID:19709 EP_NO: N/A Repair Type: Non-Urgent Crossing Status: Found UCIP Comments: Pipe not visible and may need to have silt removed from outlet on WS toe. FIELD_STRUCT_DESC: 24-inch C.M. stormdrain pipe through the levee, 16-feet below the crown. Flap gate on the waterward end. Slidegate on concrete headwall at LS toe. Concrete saddle and apron on the waterward end. (USACE-1967). This entry matches the Drainage or Irrigation Structure referenced in O&M manual (HLM 13.72). FS Date: 4/22/2014

Walkway to gatevalve on LS shoulder.

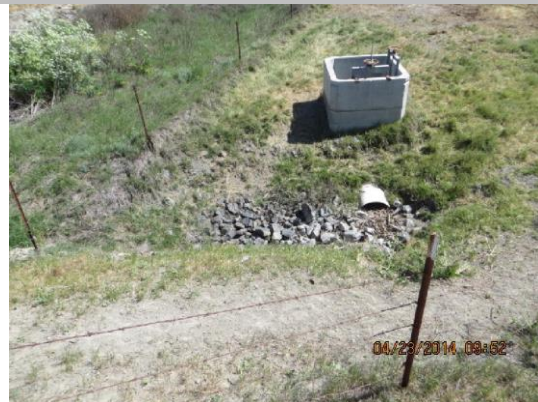
Photo 1 of 2 : UCIP_SP_2016_34664_62454.jpg

LM Start	15.11	Rating **	M	Issue No.	1320
LM End	15.11	Issue Type +	En	Location *	LS
Category	Supplemental			GPS Latitude/Longitude	
				Start	End
Item	DWR UCIP Field Study			37.156805 °	37.156805 °
				-120.609513 °	-120.609513 °
DWR ID					
Comment Code					
Inspector Comment					
FS_ID:34664					
DS_ID:19712					
EP_NO: N/A					
Repair Type: Non-Urgent					
Crossing Status: Found					
UCIP Comments: Minor erosion at headwall on WS toe.					
FIELD_STRUCT_DESC: 36-inch C.M. stormdrain pipe through the					
levee, 11.9 feet below the crown. Flap gate on the waterward end.					
Concrete headwall on both ends. (USACE-1967). This entry matches					
the Drainage or Irrigation Structure referenced in O&M manual (HLM					
15.09).					
FS Date: 4/23/2014

Headwall and inlet on LS toe.

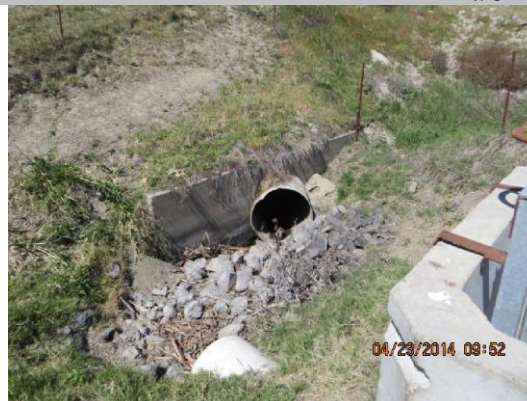
Photo 2 of 2 : UCIP_SP_2016_34664_62453.jpg

LM Start	15.11	Rating **	M	Issue No.	1320 (cont)	
LM End	15.11	Issue Type +	En	Location *	LS	
Category	Supplemental			GPS Latitude/Longitude		
				Start	End	
Item	DWR UCIP Field Study			37.156805 °	37.156805 °	
				-120.609513 °	-120.609513 °	
DWR ID						
Comment Code						
Inspector Comment						
FS_ID:34664 DS_ID:19712 EP_NO: N/A Repair Type: Non-Urgent Crossing Status: Found UCIP Comments: Minor erosion at headwall on WS toe. FIELD_STRUCT_DESC: 36-inch C.M. stormdrain pipe through the levee, 11.9 feet below the crown. Flap gate on the waterward end. Concrete headwall on both ends. (USACE-1967). This entry matches the Drainage or Irrigation Structure referenced in O&M manual (HLM 15.09). FS Date: 4/23/2014

Headwall and inlet on LS toe.

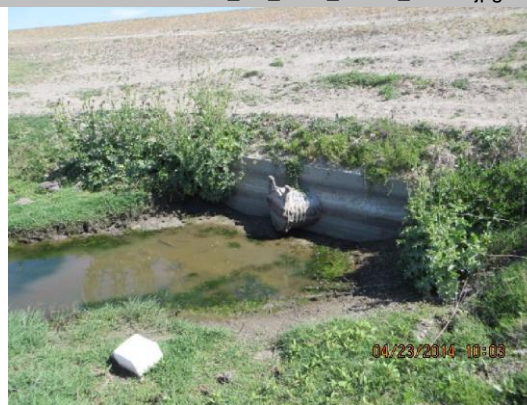
Photo 1 of 2 : UCIP_SP_2016_39595_62459.jpg

LM Start	15.76	Rating **	M	Issue No.	1352
LM End	15.76	Issue Type +	En	Location *	LS
Category	Supplemental			GPS Latitude/Longitude	
				Start	End
Item	DWR UCIP Field Study			37.150012 °	37.150012 °
				-120.601330 °	-120.601330 °
DWR ID					
Comment Code					
Inspector Comment					
FS_ID:39595 DS_ID:19713 EP_NO: N/A Repair Type: Non-Urgent Crossing Status: Found UCIP Comments: Sediment buildup in pipe visible from landward side-- recommend contacting owner to clear pipe. FIELD_STRUCT_DESC: 24-inch C.M. Stormdrain pipe through the levee, 11.0 feet below the crown. Flap gate on the waterward end. Concrete headwalls on both ends. (USACE-1967). This entry matches the Drainage or Irrigation Structure referenced in O&M manual (HLM 15.74). FS Date: 4/23/2014

Headwall, pipe, and flapgate on WS toe.

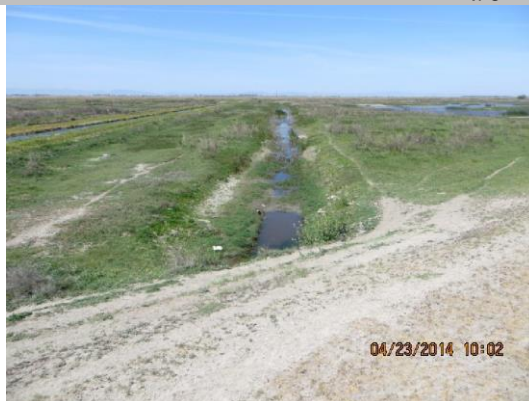
Photo 2 of 2 : UCIP_SP_2016_39595_62456.jpg

LM Start	15.76	Rating **	M	Issue No.	1352 (cont)	
LM End	15.76	Issue Type +	En	Location *	LS	
Category	Supplemental			GPS Latitude/Longitude		
				Start		End
Item	DWR UCIP Field Study			37.150012 °		37.150012 °
				-120.601330 °		-120.601330 °
DWR ID						
Comment Code						
Inspector Comment						
FS_ID:39595 DS_ID:19713 EP_NO: N/A Repair Type: Non-Urgent Crossing Status: Found UCIP Comments: Sediment buildup in pipe visible from landward side--recommend contacting owner to clear pipe. FIELD_STRUCT_DESC: 24-inch C.M. Stormdrain pipe through the levee, 11.0 feet below the crown. Flap gate on the waterward end. Concrete headwalls on both ends. (USACE-1967). This entry matches the Drainage or Irrigation Structure referenced in O&M manual (HLM 15.74). FS Date: 4/23/2014

Headwall, pipe, and flapgate on WS toe.

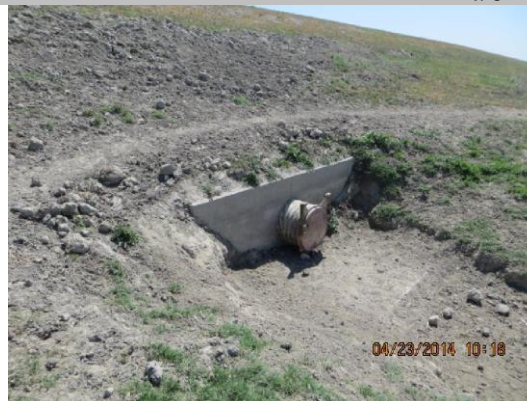
Photo 2 of 2 : UCIP_SP_2016_34725_62471.jpg

LM Start	16.68	Rating **	M	Issue No.	1322 (cont)
LM End	16.68	Issue Type +	En	Location *	LS
Category	Supplemental			GPS Latitude/Longitude	
				Start	End
Item	DWR UCIP Field Study			37.138760 °	37.138760 °
				-120.592393 °	-120.592393 °
DWR ID					
Comment Code					
Inspector Comment					
FS_ID:34725					
DS_ID:19716					
EP_NO: N/A					
Repair Type: Non-Urgent					
Crossing Status: Found					
UCIP Comments: Pipe heavily silted on LS toe.					
FIELD_STRUCT_DESC: 24-inch C.M. stormdrain pipe through the					
levee, 10.5-feet below the crown. Flap gate on the waterward end.					
Concrete headwall on both ends. (USACE-1967). This entry matches the					
Drainage or Irrigation Structure referenced in O&M manual (HLM					
16.67).					
FS Date: 4/23/2014

Headwall, flapgate, and pipe visible on WS toe.

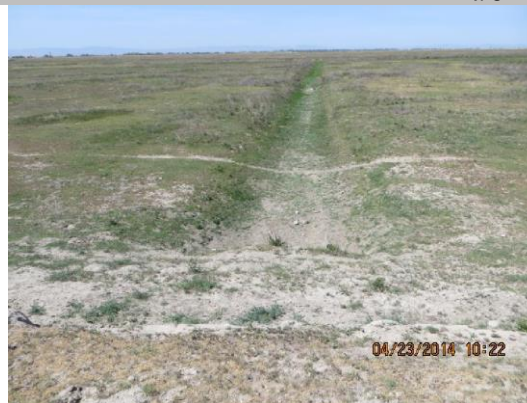
Photo 1 of 2 : UCIP_SP_2016_39597_62481.jpg

LM Start	17.22	Rating **	M	Issue No.	1354
LM End	17.22	Issue Type +	En	Location *	LS
Category	Supplemental			GPS Latitude/Longitude	
				Start	End
Item	DWR UCIP Field Study			37.132211 °	37.132211 °
				-120.587106 °	-120.587106 °
DWR ID					
Comment Code					
Inspector Comment					
FS_ID:39597 DS_ID:19717 EP_NO: N/A Repair Type: Non-Urgent Crossing Status: Found UCIP Comments: Sediment buildup in pipe visible from landward side-- recommend contacting owner to clear pipe. FIELD_STRUCT_DESC: 24-inch CM stormdrain pipe through the levee, 12-feet below the crown. Flap gate on the waterward end. Concrete headwall on both ends. (USACE-1967). This entry matches the Drainage or Irrigation Structure referenced in O&M manual (HLM 17.20). FS Date: 4/23/2014

Headwall, flapgate, and pipe visible on WS toe.

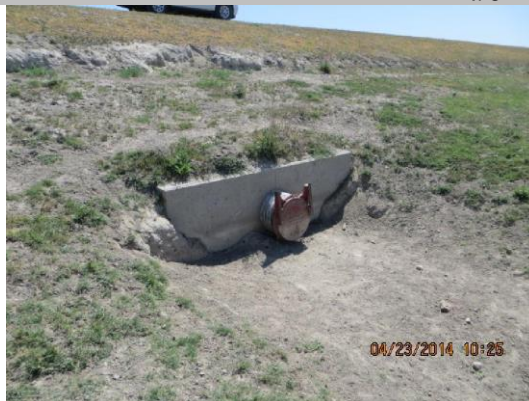
Photo 2 of 2 : UCIP_SP_2016_39597_62483.jpg

LM Start	17.22	Rating **	M	Issue No.	1354 (cont)
LM End	17.22	Issue Type +	En	Location *	LS
Category	Supplemental			GPS Latitude/Longitude	
				Start	End
Item	DWR UCIP Field Study			37.132211 °	37.132211 °
				-120.587106 °	-120.587106 °
DWR ID					
Comment Code					
Inspector Comment					
FS_ID:39597 DS_ID:19717 EP_NO: N/A Repair Type: Non-Urgent Crossing Status: Found UCIP Comments: Sediment buildup in pipe visible from landward side-- recommend contacting owner to clear pipe. FIELD_STRUCT_DESC: 24-inch CM stormdrain pipe through the levee, 12-feet below the crown. Flap gate on the waterward end. Concrete headwall on both ends. (USACE-1967). This entry matches the Drainage or Irrigation Structure referenced in O&M manual (HLM 17.20). FS Date: 4/23/2014

Headwall, flapgate, and pipe visible on WS toe.
