**Flood Control Project Maintenance
Levee Inspections****LMA District Cover Sheet****Spring 2016 Levee Inspection Results****Lower San Joaquin Levee District**

Spring 2016 Levee Inspection Results

Lower San Joaquin Levee District

Waterway			Bank	Unit Miles
Unit No. 01 San Joaquin River			Right	22.52
	Spring (March - May)	Summer (June - August)	(September - November) Fall	Winter (December - February)
Unit Maintenance Rating (Fall Only)				
Date of Inspection	5/16/2016 - 5/19/2016			
DWR Inspector	Richard Willoughby			
Accompanied By

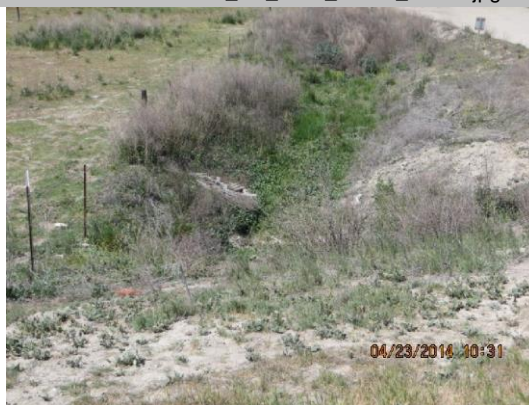
Photo 1 of 2 : UCIP_SP_2016_39599_62485.jpg

LM Start	17.54	Rating **	M	Issue No.	1355
LM End	17.54	Issue Type +	En	Location *	LS
Category	Supplemental			GPS Latitude/Longitude	
				Start	End
Item	DWR UCIP Field Study			37.127843 °	37.127843 °
				-120.585245 °	-120.585245 °
DWR ID					
Comment Code					
Inspector Comment					
FS_ID:39599 DS_ID:19743 EP_NO: N/A Repair Type: Non-Urgent Crossing Status: Found UCIP Comments: Sediment buildup in pipe visible from landward side-- recommend contacting owner to clear pipe. FIELD_STRUCT_DESC: 24-inch CM stormdrain pipe through the levee, 9.8-feet below the crown. Flap gate on the waterward end. Concrete headwall on both ends. (USACE-1967). This entry matches the Drainage or Irrigation Structure referenced in O&M manual (HLM 17.52). FS Date: 4/23/2014

Headwall, pipe, and flapgate visible on WS toe.

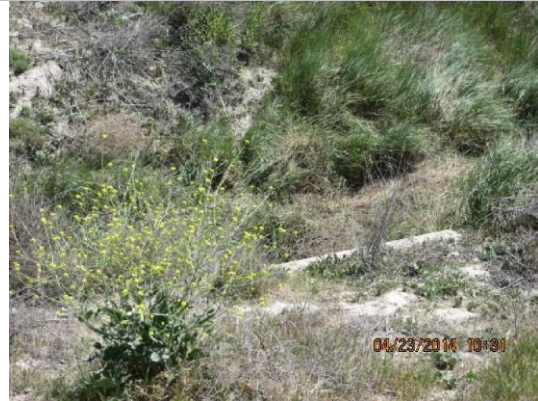
Photo 2 of 2 : UCIP_SP_2016_39599_62486.jpg

LM Start	17.54	Rating **	M	Issue No.	1355 (cont)	
LM End	17.54	Issue Type +	En	Location *	LS	
Category	Supplemental			GPS Latitude/Longitude		
				Start		End
Item	DWR UCIP Field Study			37.127843 °		37.127843 °
				-120.585245 °		-120.585245 °
DWR ID						
Comment Code						
Inspector Comment						
FS_ID:39599						
DS_ID:19743						
EP_NO: N/A						
Repair Type: Non-Urgent						
Crossing Status: Found						
UCIP Comments: Sediment buildup in pipe visible from landward side--recommend contacting owner to clear pipe.						
FIELD_STRUCT_DESC: 24-inch CM stormdrain pipe through the levee, 9.8-feet below the crown. Flap gate on the waterward end. Concrete headwall on both ends. (USACE-1967). This entry matches the Drainage or Irrigation Structure referenced in O&M manual (HLM 17.52).						
FS Date: 4/23/2014

Pipe and headwall visible on LS toe.

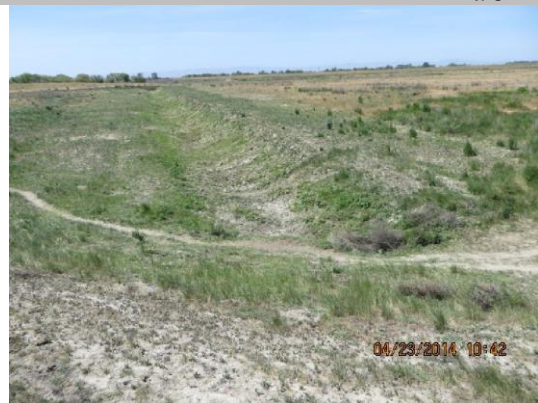
Photo 1 of 2 : UCIP_SP_2016_34747_62494.jpg

LM Start	18.09	Rating **	M	Issue No.	1323
LM End	18.09	Issue Type +	En	Location *	LS
Category	Supplemental			GPS Latitude/Longitude	
				Start	End
Item	DWR UCIP Field Study			37.120309 °	37.120309 °
				-120.582041 °	-120.582041 °
DWR ID					
Comment Code					
Inspector Comment					
FS_ID:34747					
DS_ID:19745					
EP_NO: N/A					
Repair Type: Non-Urgent					
Crossing Status: Found					
UCIP Comments: Animal burrows in levee on both slopes.					
FIELD_STRUCT_DESC: 24-inch C.M. stormdrain pipe through the					
levee, 12.4-feet below the crown. Flap gate on the waterward end.					
Concrete headwall on both ends. (USACE-1967). This entry matches					
the Drainage or Irrigation Structure referenced in O&M manual (HLM					
18.07).					
FS Date: 4/23/2014

Headwall, pipe, and flapgate on WS toe.

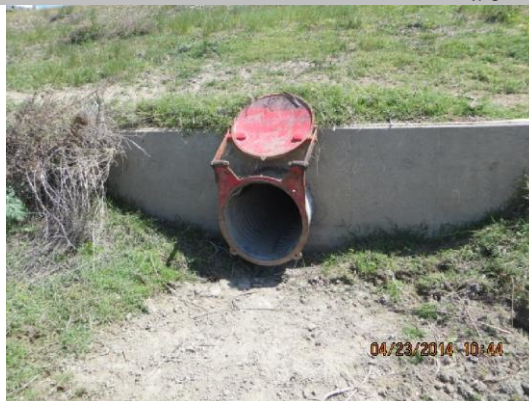
Photo 2 of 2 : UCIP_SP_2016_34747_62495.jpg

LM Start	18.09	Rating **	M	Issue No.	1323 (cont)	
LM End	18.09	Issue Type +	En	Location *	LS	
Category	Supplemental			GPS Latitude/Longitude		
				Start	End	
Item	DWR UCIP Field Study			37.120309 °	37.120309 °	
				-120.582041 °	-120.582041 °	
DWR ID						
Comment Code						
Inspector Comment						
FS_ID:34747						
DS_ID:19745						
EP_NO: N/A						
Repair Type: Non-Urgent						
Crossing Status: Found						
UCIP Comments: Animal burrows in levee on both slopes.						
FIELD_STRUCT_DESC: 24-inch C.M. stormdrain pipe through the						
levee, 12.4-feet below the crown. Flap gate on the waterward end.						
Concrete headwall on both ends. (USACE-1967). This entry matches the						
Drainage or Irrigation Structure referenced in O&M manual (HLM						
18.07).						
FS Date: 4/23/2014

Headwall, pipe, and flapgate on WS toe.

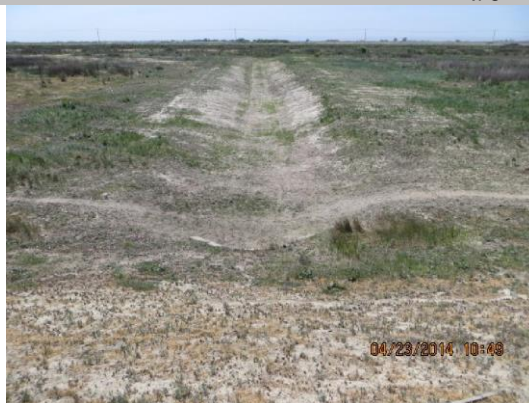
Photo 1 of 2 : UCIP_SP_2016_39600_62499.jpg

Comment Code					
Inspector Comment					
FS_ID:39600					
DS_ID:19746					
EP_NO: N/A					
Repair Type: Non-Urgent					
Crossing Status: Found					
UCIP Comments: Dense vegetation limits the inspector's visibility to identify signs of pipe failure (leaks) along the landward slope.					
Recommend removing vegetation along pipe alignment to conduct proper inspection of structure.					
FIELD_STRUCT_DESC: 24-inch C.M. stormdrain pipe through the levee, 10.0-feet below the crown. Flap gate on the waterward end. Concrete headwall on the landward end. Concrete "U" headwall on the waterward end. (USACE-1967). This entry matches the Drainage or Irrigation Structure referenced in O&M manual (HLM 18.68).					
FS Date: 4/23/2014

Headwall, pipe and flapgate visible on WS toe.

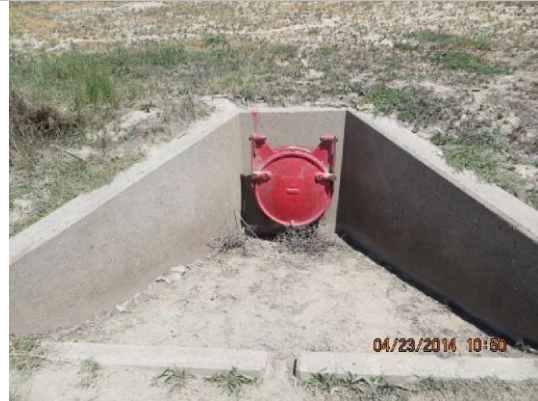
Photo 2 of 2 : UCIP_SP_2016_39600_62498.jpg

Item	DWR UCIP Field Study			37.115472 °	37.115472 °	
				-120.573628 °	-120.573628 °	
DWR ID						
Comment Code						
Inspector Comment						
FS_ID:39600 DS_ID:19746 EP_NO: N/A Repair Type: Non-Urgent Crossing Status: Found UCIP Comments: Dense vegetation limits the inspector's visibility to identify signs of pipe failure (leaks) along the landward slope. Recommend removing vegetation along pipe alignment to conduct proper inspection of structure. FIELD_STRUCT_DESC: 24-inch C.M. stormdrain pipe through the levee, 10.0-feet below the crown. Flap gate on the waterward end. Concrete headwall on the landward end. Concrete "U" headwall on the waterward end. (USACE-1967). This entry matches the Drainage or Irrigation Structure referenced in O&M manual (HLM 18.68). FS Date: 4/23/2014

Headwall, pipe and flapgate visible on WS toe.

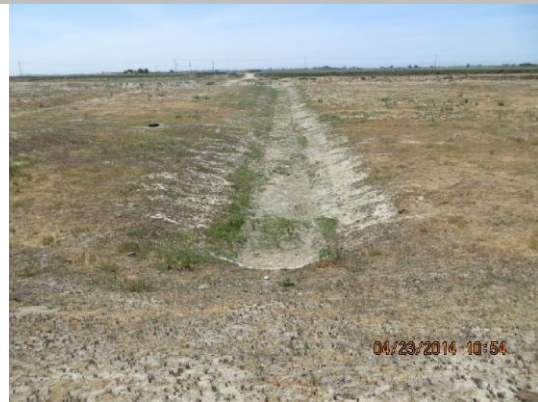
Photo 1 of 2 : UCIP_SP_2016_39601_62504.jpg

LM Start	19.15	Rating **	M	Issue No.	1357
LM End	19.15	Issue Type +	En	Location *	LS
Category	Supplemental			GPS Latitude/Longitude	
				Start	End
Item	DWR UCIP Field Study			37.115466 °	37.115466 °
				-120.565467 °	-120.565467 °
DWR ID					
Comment Code					
Inspector Comment					
FS_ID:39601 DS_ID:19747 EP_NO: N/A Repair Type: Non-Urgent Crossing Status: Found UCIP Comments: Sediment buildup in pipe visible from landward side-- recommend contacting owner to clear pipe. FIELD_STRUCT_DESC: 24-inch C.M. stormdrain pipe through the levee, 10.0-feet below the crown. Flap gate on the waterward end. Concrete headwall on the landward end. Concrete "U" headwall on the waterward end. (USACE-1967). This entry matches the Drainage or Irrigation Structure referenced in O&M manual (HLM 19.11). FS Date: 4/23/2014

Headwall, pipe, and flapgate visible on WS toe.

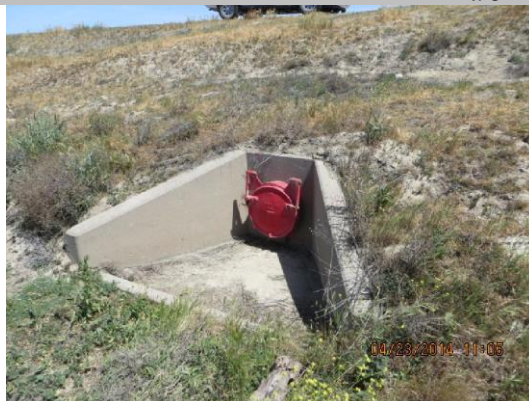
Photo 2 of 2 : UCIP_SP_2016_39602_62516.jpg

LM Start	19.48	Rating **	M	Issue No.	1358 (cont)
LM End	19.48	Issue Type +	En	Location *	LS
Category	Supplemental			GPS Latitude/Longitude	
				Start	End
Item	DWR UCIP Field Study			37.113542 °	37.113542 °
				-120.560389 °	-120.560389 °
DWR ID					
Comment Code					
Inspector Comment					
FS_ID:39602 DS_ID:19777 EP_NO: N/A Repair Type: Non-Urgent Crossing Status: Found UCIP Comments: Sediment buildup in pipe visible from landward side-- recommend contacting owner to clear pipe. FIELD_STRUCT_DESC: 24-inch C.M. stormdrain pipe through the levee, 9.0-feet below the crown. Flap gate on the waterward end. Concrete headwall on the landward end. Concrete "U" headwall on the waterward end. (USACE-1967). This entry matches the Drainage or Irrigation Structure referenced in O&M manual (HLM 19.46). FS Date: 4/23/2014

Headwall, pipe, and flapgate visible on WS toe.

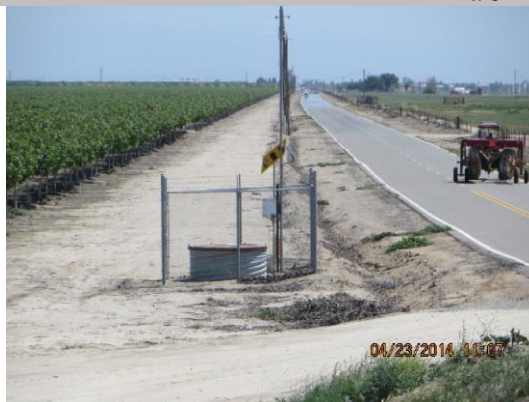
Photo 1 of 2 : UCIP_SP_2016_39345_71477.jpg

LM Start	19.51	Rating **	M	Issue No.	1335
LM End	19.51	Issue Type +	En	Location *	LS
Category	Supplemental			GPS Latitude/Longitude	
				Start	End
Item	DWR UCIP Field Study			37.113172 °	37.113172 °
				-120.560014 °	-120.560014 °
DWR ID					
Comment Code					
Inspector Comment					
FS_ID:39345 DS_ID:24868 EP_NO: N/A Repair Type: Non-Urgent Crossing Status: Indicator Found UCIP Comments: Markers closer to the levee may be necessary to properly mark pipe crossing location. FIELD_STRUCT_DESC: Gasline of unknown diameter at unknown depth below the crown. CMP riser and gasline marker off LS toe. FS Date: 4/22/2014

Gasline marker off LS toe.

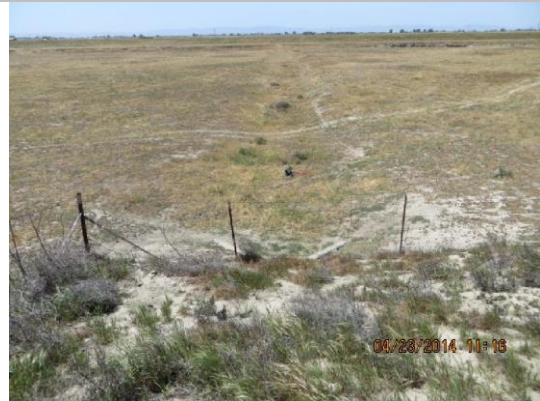
Photo 1 of 2 : UCIP_SP_2016_39603_62519.jpg

Comment Code						
Inspector Comment						
FS_ID:39603 DS_ID:19778 EP_NO: N/A Repair Type: Non-Urgent Crossing Status: Found UCIP Comments: Dense vegetation limits the inspector's visibility to identify signs of pipe failure (leaks) along the landward slope. Recommend removing vegetation along pipe alignment to conduct proper inspection of structure. Sediment buildup in pipe visible from landward side--recommend contacting owner to clear pipe. FIELD_STRUCT_DESC: 24-inch C.M. stormdrain pipe through the levee, 9.7 feet below the crown. Flap gate on the waterward end. Concrete headwall on the landward end. Concrete "U" headwall on the waterward end. (USACE-1967). This entry matches the Drainage or Irrigation Structure referenced in O&M manual (HLM 19.50). FS Date: 4/23/2014

Headwall, pipe, and flapgate visible on WS toe.

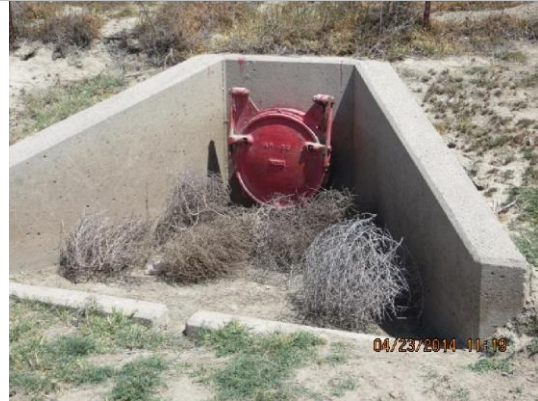
Photo 2 of 2 : UCIP_SP_2016_39603_62521.jpg

Item	DWR UCIP Field Study			37.112953 °	37.112953 °	
				-120.559943 °	-120.559943 °	
DWR ID						
Comment Code						
Inspector Comment						
FS_ID:39603 DS_ID:19778 EP_NO: N/A Repair Type: Non-Urgent Crossing Status: Found UCIP Comments: Dense vegetation limits the inspector's visibility to identify signs of pipe failure (leaks) along the landward slope. Recommend removing vegetation along pipe alignment to conduct proper inspection of structure. Sediment buildup in pipe visible from landward side--recommend contacting owner to clear pipe. FIELD_STRUCT_DESC: 24-inch C.M. stormdrain pipe through the levee, 9.7 feet below the crown. Flap gate on the waterward end. Concrete headwall on the landward end. Concrete "U" headwall on the waterward end. (USACE-1967). This entry matches the Drainage or Irrigation Structure referenced in O&M manual (HLM 19.50). FS Date: 4/23/2014

Headwall, pipe, and flapgate visible on WS toe.

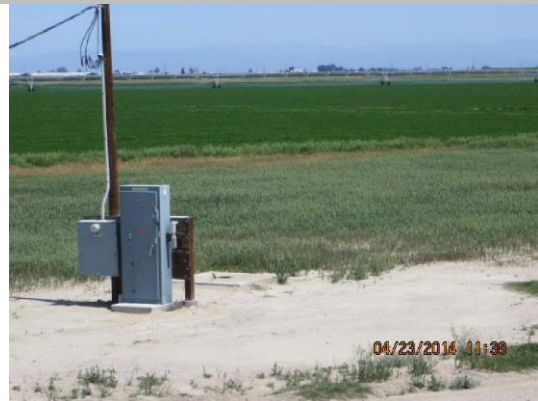
Photo 1 of 1 : UCIP_SP_2016_34759_62537.jpg

LM Start	20.19	Rating **	M	Issue No.	1324
LM End	20.19	Issue Type +	En	Location *	LS
Category	Supplemental			GPS Latitude/Longitude	
				Start	End
Item	DWR UCIP Field Study			37.106149 °	37.106149 °
				-120.552538 °	-120.552538 °
DWR ID					
Comment Code					
Inspector Comment					
FS_ID:34759 DS_ID:19782 EP_NO: 13828 Repair Type: Non-Urgent Crossing Status: Not Found UCIP Comments: FIELD_STRUCT_DESC: *DELETE* NOT INSTALLED THROUGH THE LEVEE. 24-inch steel irrigation pipe through the levee, 4.0 feet below the crown. Pump missing from pad on the landward side. Steel cutoff wall around pipe at center of levee. Siphon breaker on apex of pipe on landward shoulder. Pre-existing ditch runs from waterward toe to channel. Pipe extends from pump to the channel. Rock revetment on the cut slopes of the inlet channel. (Permit No. 13828-1988) FS Date: 4/23/2014

Well head visible off LS toe.

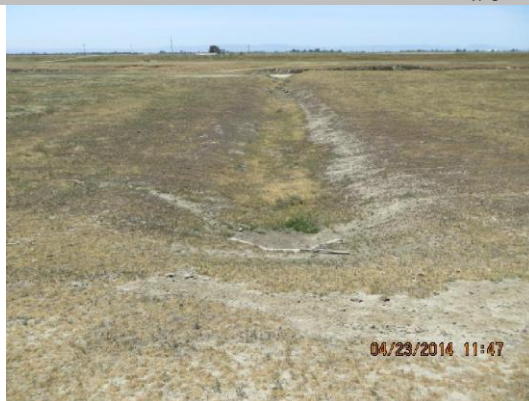
Photo 1 of 2 : UCIP_SP_2016_39605_62544.jpg

Comment Code					
Inspector Comment					
FS_ID:39605 DS_ID:19784 EP_NO: N/A Repair Type: Non-Urgent Crossing Status: Found UCIP Comments: Dense vegetation limits the inspector's visibility to identify signs of pipe failure (leaks) along the landward slope. Recommend removing vegetation along pipe alignment to conduct proper inspection of structure. FIELD_STRUCT_DESC: 24-inch C.M. pipe through the levee, 10.5 feet below the crown. Flap gate on the waterward end. Concrete headwall on the landward end. Concrete "U" headwall on the waterward end. (USACE-1967). This entry matches the Drainage or Irrigation Structure referenced in O&M manual (HLM 20.59). FS Date: 4/23/2014

Headwall, pipe, and flapgate visible on WS toe.

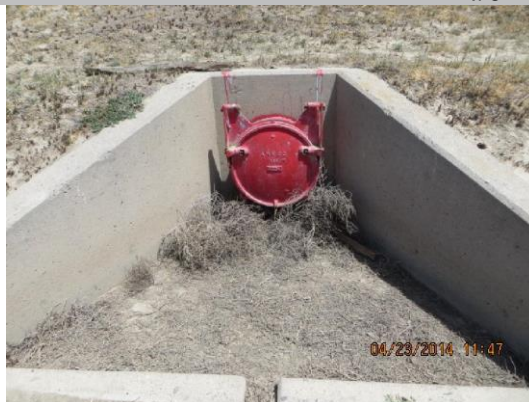
Photo 2 of 2 : UCIP_SP_2016_39605_62543.jpg

Headwall, pipe, and flapgate visible on WS toe.

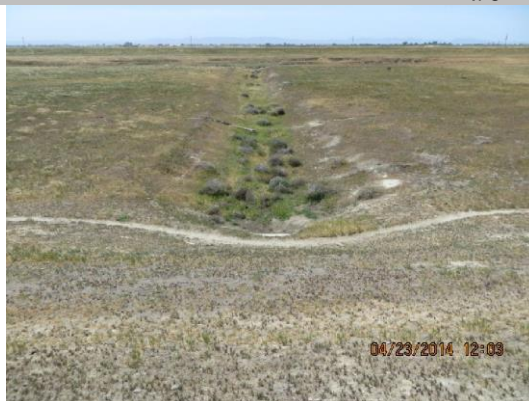
Photo 1 of 2 : UCIP_SP_2016_39606_62549.jpg

Comment Code					
Inspector Comment					
FS_ID:39606 DS_ID:19785 EP_NO: N/A Repair Type: Non-Urgent Crossing Status: Found UCIP Comments: Dense vegetation limits the inspector's visibility to identify signs of pipe failure (leaks) along the landward slope. Recommend removing vegetation along pipe alignment to conduct proper inspection of structure. FIELD_STRUCT_DESC: 24-inch C.M. stormdrain pipe through the levee, 11.8-feet below the crown. Flap gate on the waterward end. Concrete headwall on the landward end. Concrete "U" headwall on the waterward end. (USACE-1967). This entry matches the Drainage or Irrigation Structure referenced in O&M manual (HLM 21.08). FS Date: 4/23/2014

Headwall, pipe, and flapgate visible on WS toe.

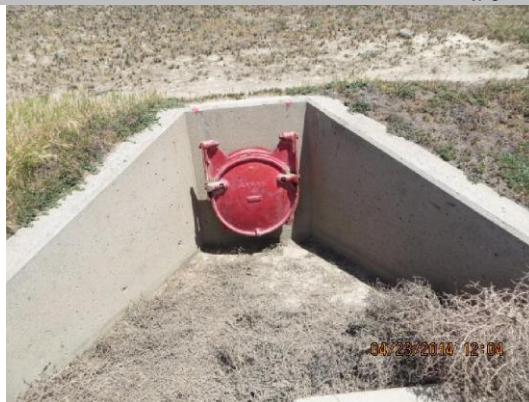
Photo 2 of 2 : UCIP_SP_2016_39606_62551.jpg

Headwall, pipe, and flapgate visible on WS toe.

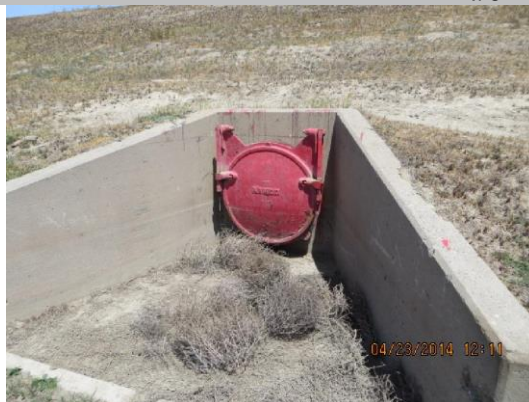
Photo 2 of 2 : UCIP_SP_2016_39614_62556.jpg

FS_ID:39614
DS_ID:19786
EP_NO: N/A
Repair Type: Non-Urgent
Crossing Status: Found
UCIP Comments: Dense vegetation limits the inspector's visibility to identify signs of pipe failure (leaks) along the landward slope. Recommend removing vegetation along pipe alignment to conduct proper inspection of structure.
FIELD_STRUCT_DESC: 36-inch C.M. stormdrain pipe through the levee, 12.7-feet below the crown. Flap gate on the waterward end. Concrete headwall on the landward end. Concrete "U" headwall on the waterward end. (USACE-1967). This entry matches the Drainage or Irrigation Structure referenced in O&M manual (HLM 21.42).
FS Date: 4/23/2014

Headwall, pipe, and flapgate visible on WS toe.

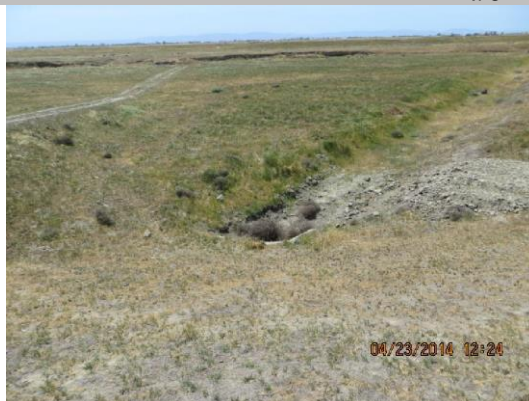
Photo 1 of 2 : UCIP_SP_2016_39883_62559.jpg

Comment Code					
Inspector Comment					
FS_ID:39883 DS_ID:19787 EP_NO: N/A Repair Type: Non-Urgent Crossing Status: Found UCIP Comments: Dense vegetation limits the inspector's visibility to identify signs of pipe failure (leaks) along the landward slope. Recommend removing vegetation along pipe alignment to conduct proper inspection of structure. FIELD_STRUCT_DESC: 24-inch C.M. stormdrain pipe through the levee, 12.4-feet below the crown. Flap gate on the waterward end. Concrete headwall on the landward end. Concrete "U" headwall on the waterward end. (USACE-1967). This entry matches the Drainage or Irrigation Structure referenced in O&M manual (HLM 21.81). FS Date: 4/23/2014

Headwall, pipe, and flapgate visible on WS toe.

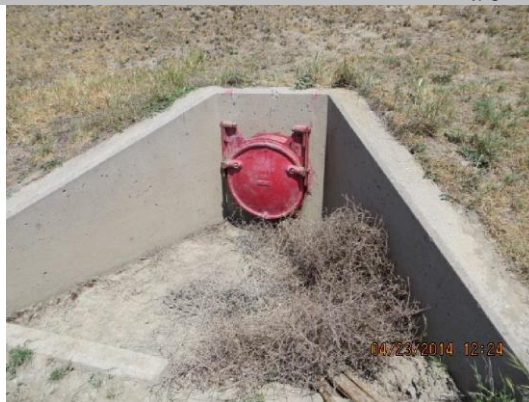
Photo 2 of 2 : UCIP_SP_2016_39883_62558.jpg

Headwall, pipe, and flapgate visible on WS toe.

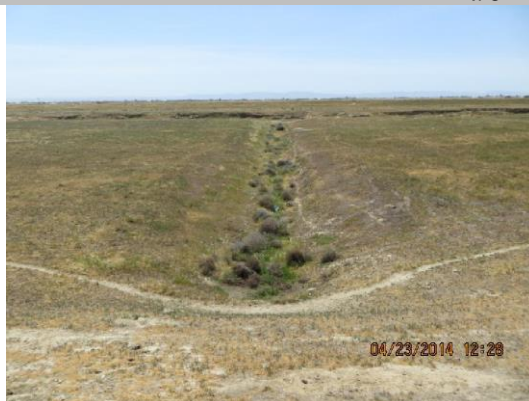
Photo 1 of 2 : UCIP_SP_2016_39610_62586.jpg

Comment Code					
Inspector Comment					
FS_ID:39610 DS_ID:19788 EP_NO: N/A Repair Type: Non-Urgent Crossing Status: Found UCIP Comments: Dense vegetation limits the inspector's visibility to identify signs of pipe failure (leaks) along the landward slope. Recommend removing vegetation along pipe alignment to conduct proper inspection of structure. FIELD_STRUCT_DESC: 24-inch C.M. stormdrain pipe through the levee, 10.7-feet below the crown. Flap gate on the waterward end. Concrete headwall on the landward end. Concrete "U" headwall on the waterward end. (USACE-1967). This entry matches the Drainage or Irrigation Structure referenced in O&M manual (HLM 21.85). FS Date: 4/23/2014

Headwall, pipe, and flapgate visible on WS toe.

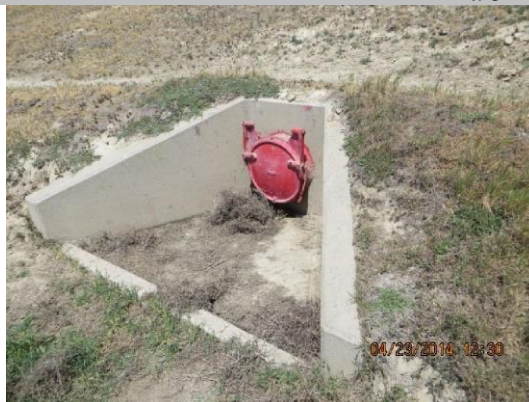
Photo 2 of 2 : UCIP_SP_2016_39610_62588.jpg

Headwall, pipe, and flapgate visible on WS toe.

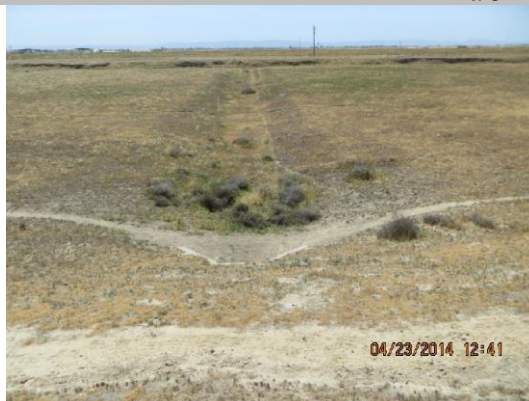
Photo 1 of 2 : UCIP_SP_2016_39611_62591.jpg

Comment Code					
Inspector Comment					
FS_ID:39611 DS_ID:19789 EP_NO: N/A Repair Type: Non-Urgent Crossing Status: Found UCIP Comments: Dense vegetation limits the inspector's visibility to identify signs of pipe failure (leaks) along the landward slope. Recommend removing vegetation along pipe alignment to conduct proper inspection of structure. Sediment buildup in pipe visible from landward side--recommend contacting owner to clear pipe. FIELD_STRUCT_DESC: 24-inch C.M. stormdrain pipe through the levee, 10.2-feet below the crown. Flap gate on the waterward end. Concrete headwall on the landward end. Concrete "U" headwall on the waterward end. (USACE-1967). This entry matches the Drainage or Irrigation Structure referenced in O&M manual (HLM 22.19). FS Date: 4/23/2014

Headwall, pipe, and flapgate visible on WS toe.

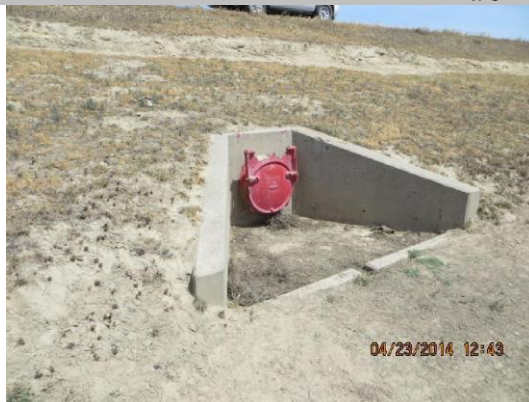
Photo 2 of 2 : UCIP_SP_2016_39611_62593.jpg

Headwall, pipe, and flapgate visible on WS toe.

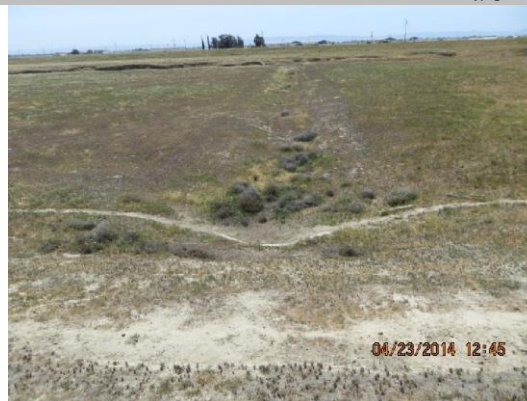
Photo 1 of 2 : UCIP_SP_2016_39613_62596.jpg

Comment Code					
Inspector Comment					
FS_ID:39613 DS_ID:19790 EP_NO: N/A Repair Type: Non-Urgent Crossing Status: Found UCIP Comments: Dense vegetation limits the inspector's visibility to identify signs of pipe failure (leaks) along the landward slope. Recommend removing vegetation along pipe alignment to conduct proper inspection of structure. Sediment buildup in pipe visible from landward side--recommend contacting owner to clear pipe. FIELD_STRUCT_DESC: 24-inch C.M. stormdrain pipe through the levee, 10.4-feet below the crown. Flap gate on the waterward end. Concrete headwall on the landward end. Concrete "U" headwall on the waterward end. (USACE-1967). This entry matches the Drainage or Irrigation Structure referenced in O&M manual (HLM 22.79). FS Date: 4/23/2014

Headwall, pipe, and flapgate visible on WS toe.

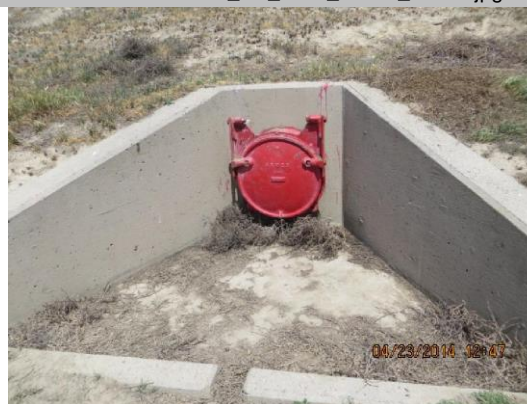
Photo 2 of 2 : UCIP_SP_2016_39613_62598.jpg

Headwall, pipe, and flapgate visible on WS toe.

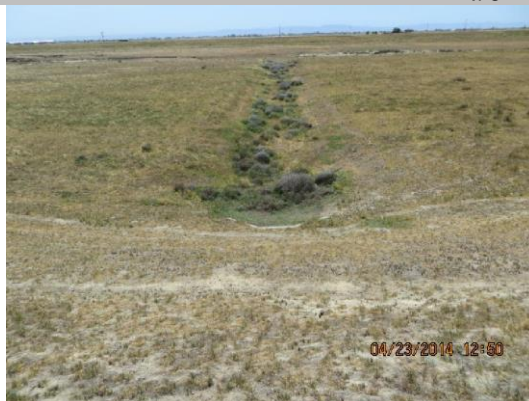
Photo 1 of 2 : UCIP_SP_2016_39616_62601.jpg

Comment Code					
Inspector Comment					
FS_ID:39616 DS_ID:19791 EP_NO: N/A Repair Type: Non-Urgent Crossing Status: Found UCIP Comments: Dense vegetation limits the inspector's visibility to identify signs of pipe failure (leaks) along the landward slope. Recommend removing vegetation along pipe alignment to conduct proper inspection of structure. Sediment buildup in pipe visible from landward side--recommend contacting owner to clear pipe. FIELD_STRUCT_DESC: 24-inch C.M. stormdrain pipe through the levee, 12.2-feet below the crown. Flap gate on the waterward end. Concrete headwall on the landward end. Concrete "U" headwall on the waterward end. (USACE-1967). This entry matches the Drainage or Irrigation Structure referenced in O&M manual (HLM 22.94). FS Date: 4/23/2014

Headwall, pipe, and flapgate visible on WS toe.

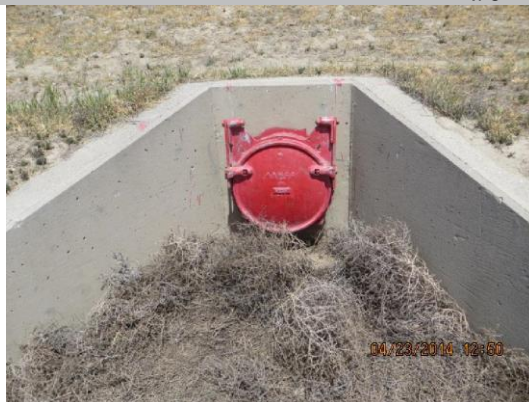
Photo 2 of 2 : UCIP_SP_2016_39616_62600.jpg

Headwall, pipe, and flapgate visible on WS toe.

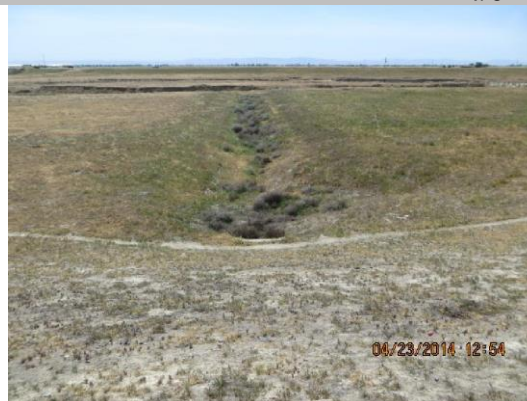
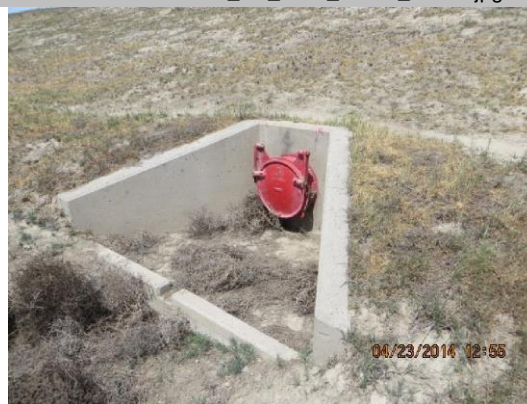
LM Start	23.03	Rating **	M	Issue No.	1367 (cont)
LM End	23.03	Issue Type +	En	Location *	LS

Comment Code					
Inspector Comment					
FS_ID:39617					
DS_ID:19792					
EP_NO: N/A					
Repair Type: Non-Urgent					
Crossing Status: Found					
UCIP Comments: Dense vegetation limits the inspector's visibility to identify signs of pipe failure (leaks) along the landward slope.					
Recommend removing vegetation along pipe alignment to conduct proper inspection of structure.					
FIELD_STRUCT_DESC: 24-inch C.M. stormdrain pipe through the levee, 11.1-feet below the crown. Flap gate on the waterward end. Concrete headwall on the landward end. Concrete "U" headwall on the waterward end. (USACE-1967). This entry matches the Drainage or Irrigation Structure referenced in O&M manual (HLM 22.79).					
FS Date: 4/23/2014

Headwall, pipe, and flapgate visible on WS toe.

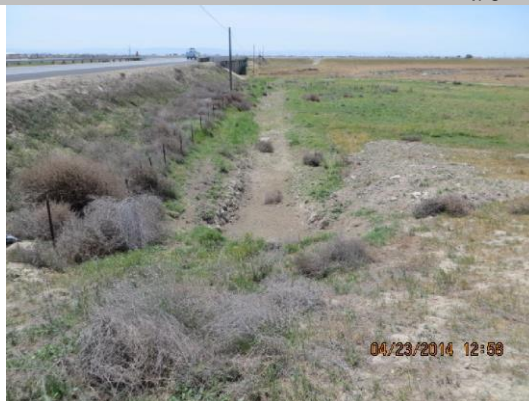
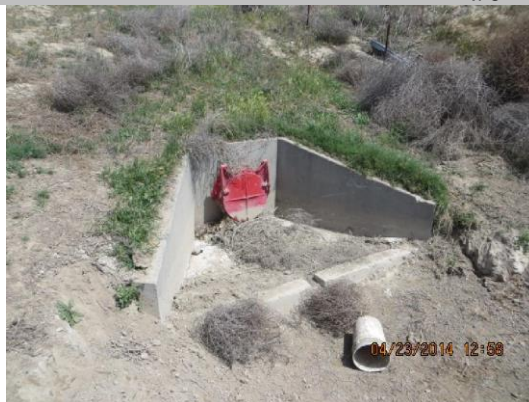
LM Start	23.17	Rating **	M	Issue No.	1368 (cont)
LM End	23.17	Issue Type +	En	Location *	LS

LM Start	23.17	Rating **	M	Issue No.	1368
LM End	23.17	Issue Type +	En	Location *	LS
Category	Supplemental			GPS Latitude/Longitude	
				Start	End
Item	DWR UCIP Field Study			37.073901 °	37.073901 °
				-120.517651 °	-120.517651 °
DWR ID					
Comment Code					
Inspector Comment					
FS_ID:39618 DS_ID:19793 EP_NO: N/A Repair Type: Non-Urgent Crossing Status: Found UCIP Comments: Debris blocking closure of outlet. Dense vegetation limits the inspector's visibility to identify signs of pipe failure (leaks) along the waterward and landward slopes. Recommend removing vegetation along pipe alignment to conduct proper inspection of structure. FIELD_STRUCT_DESC: 24-inch C.M. stormdrain pipe through the levee, 11.5-feet below the crown. Flap gate on the waterward end. Concrete headwall on the landward end. Concrete "U" headwall on the waterward end. FS Date: 4/23/2014

Headwall, pipe, and flapgate visible on WS toe.

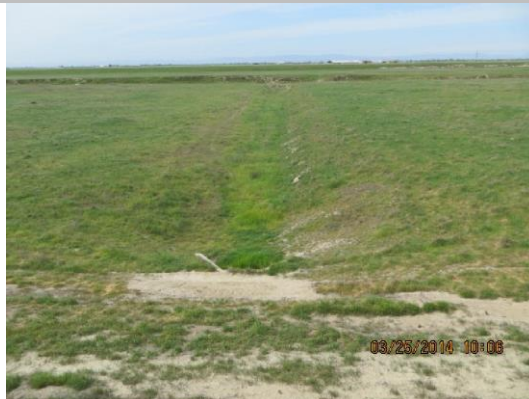
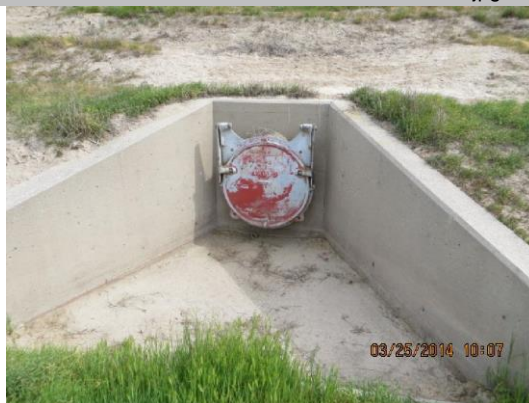
LM Start	23.72	Rating **	M	Issue No.	1370 (cont)
LM End	23.72	Issue Type +	En	Location *	LS

LM Start	23.72	Rating **	M	Issue No.	1370
LM End	23.72	Issue Type +	En	Location *	LS
Category	Supplemental			GPS Latitude/Longitude	
				Start	End
Item	DWR UCIP Field Study			37.067799 °	37.067799 °
				-120.511093 °	-120.511093 °
DWR ID					
Comment Code					
Inspector Comment					
FS_ID:39621 DS_ID:19796 EP_NO: N/A Repair Type: Non-Urgent Crossing Status: Found UCIP Comments: Sediment buildup in pipe visible from landward side--recommend contacting owner to clear pipe. FIELD_STRUCT_DESC: 30-inch C.M. pipe through the levee, 12.1 feet below the crown. Flap gate on the waterward end. Concrete "U" headwall on the waterward end. (USACE-1967). This entry matches the Drainage or Irrigation Structure referenced in O&M manual (HLM 23.62). FS Date: 3/25/2014

Concrete headwall on WS toe.

Flapgate on Concrete headwall on WS toe.

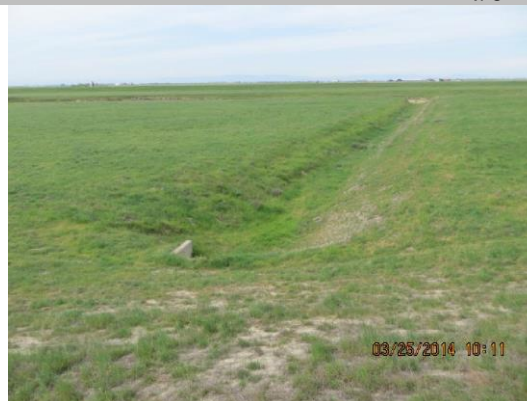
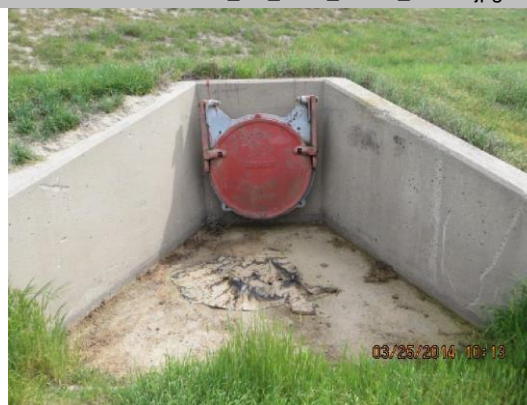
LM Start	24.02	Rating **	M	Issue No.	1369 (cont)
LM End	24.02	Issue Type +	En	Location *	LS

LM Start	24.02	Rating **	M	Issue No.	1369
LM End	24.02	Issue Type +	En	Location *	LS
Category	Supplemental			GPS Latitude/Longitude	
				Start	End
Item	DWR UCIP Field Study			37.064494 °	37.064494 °
				-120.507531 °	-120.507531 °
DWR ID					
Comment Code					
Inspector Comment					
FS_ID:39620					
DS_ID:19797					
EP_NO: N/A					
Repair Type: Non-Urgent					
Crossing Status: Found					
UCIP Comments: Minor sediment/debris buildup in pipe visible from landward side--recommend contacting owner to clear pipe.					
FIELD_STRUCT_DESC: 36-inch C.M. stormdrain pipe through the levee, 12.1 feet below the crown. Flap gate on the waterward end. Concrete headwall on the landward end. Concrete "U" headwall on the waterward end. (USACE-1967). This entry matches the Drainage or Irrigation Structure referenced in O&M manual (HLM 23.85).					
FS Date: 3/25/2014

Concrete headwall on WS toe.

Flapgate at Concrete headwall on WS toe.

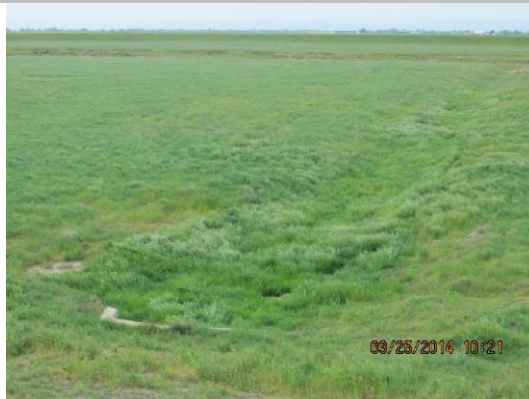
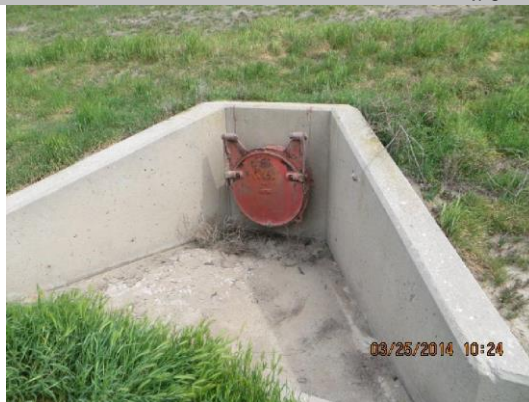
LM Start	24.28	Rating **	M	Issue No.	1376 (cont)
LM End	24.28	Issue Type +	En	Location *	LS

Comment Code					
Inspector Comment					
FS_ID:46850 DS_ID:19798 EP_NO: N/A Repair Type: Non-Urgent Crossing Status: Found UCIP Comments: Dense vegetation limits the inspector's visibility to identify signs of pipe failure (leaks) along the landward slope. Recommend removing vegetation along pipe alignment to conduct proper inspection of structure. FIELD_STRUCT_DESC: 24-inch C.M. stormdrain pipe through the levee, 11.2 feet below the crown. Flap gate on the waterward end. Concrete headwall on the landward end. Concrete "U" headwall on the waterward end. (USACE-1967). This entry matches the Drainage or Irrigation Structure referenced in O&M manual (HLM 24.18). FS Date: 3/25/2014

Concrete headwall at WS toe.

Flapgate at concrete headwall at WS toe.

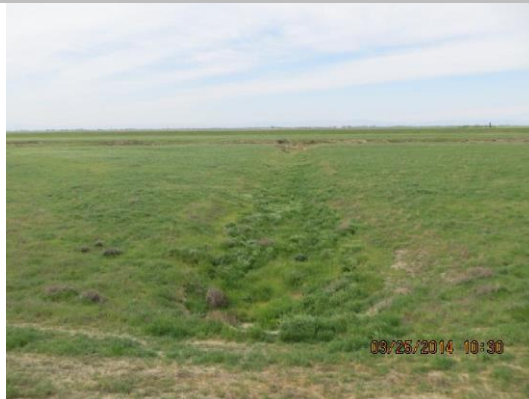
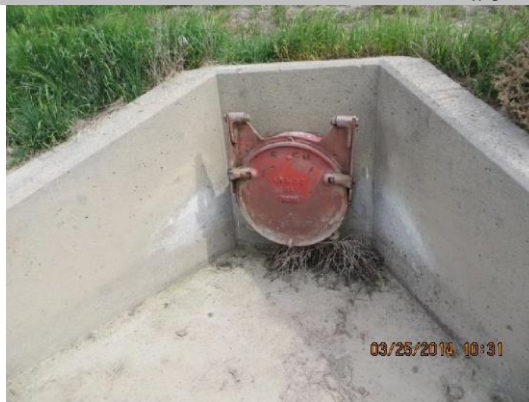
LM Start	24.56	Rating **	M	Issue No.	1371 (cont)
LM End	24.56	Issue Type +	En	Location *	LS

Comment Code					
Inspector Comment					
FS_ID:39623 DS_ID:19799 EP_NO: N/A Repair Type: Non-Urgent Crossing Status: Found UCIP Comments: Dense vegetation limits the inspector's visibility to identify signs of pipe failure (leaks) along the landward slope. Recommend removing vegetation along pipe alignment to conduct proper inspection of structure. FIELD_STRUCT_DESC: 24-inch C.M. stormdrain pipe through the levee, 11.2 feet below the crown. Flap gate on the waterward end. Concrete headwall on the landward end. Concrete "U" headwall on the waterward end. (USACE-1967). This entry matches the Drainage or Irrigation Structure referenced in O&M manual (HLM 24.46). FS Date: 3/25/2014

Concrete headwall on WS toe.

Flapgate at Concrete headwall on WS toe.

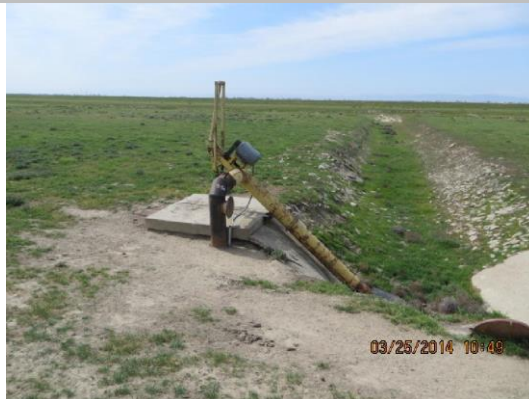
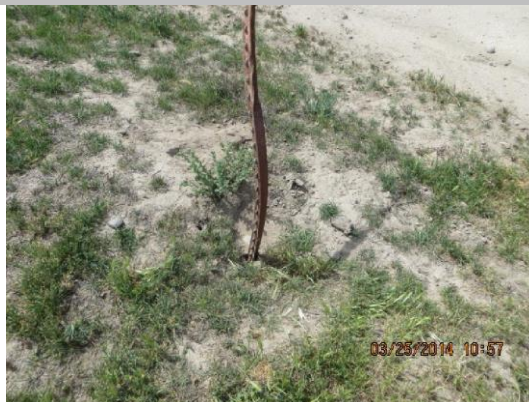
LM Start	24.98	Rating **	M	Issue No.	1336 (cont)
LM End	24.98	Issue Type +	En	Location *	LS

LM Start	24.98	Rating **	M	Issue No.	1336
LM End	24.98	Issue Type +	En	Location *	LS
Category	Supplemental			GPS Latitude/Longitude	
				Start	End
Item	DWR UCIP Field Study			37.054146 °	37.054146 °
				-120.495968 °	-120.495968 °
DWR ID					
Comment Code					
Inspector Comment					
FS_ID:41716 DS_ID:19802 EP_NO: 12873 Repair Type: Non-Urgent Crossing Status: Found UCIP Comments: Clear soil from siphon breaker and install a protective riser. FIELD_STRUCT_DESC: 16-inch steel irrigation pipe through the levee, 2.0 feet below the crown. Siphon breaker on waterward shoulder. Slant pump at channel on WS toe. Gatevalve on LS toe. Pre-existing ditch runs from waterward toe to channel. Riprap placed around intake. 2-inch PVC electrical conduit at same location (Permit No. 12873-1981) FS Date: 3/25/2014

Slant pump at channel on WS toe.

Buried Siphon breaker on WS shoulder.

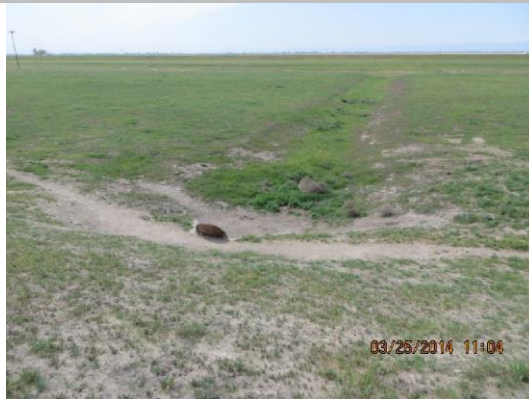
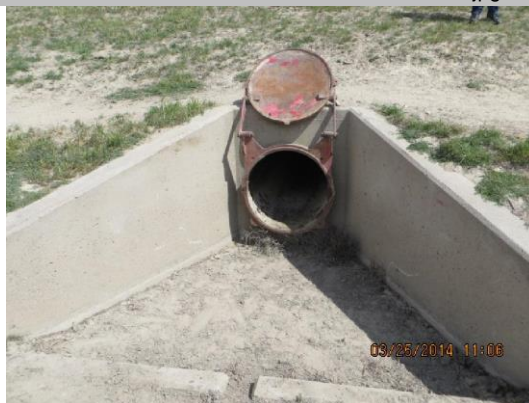
LM Start	25.24	Rating **	M	Issue No.	1312 (cont)
LM End	25.24	Issue Type +	En	Location *	LS

LM Start	25.24	Rating **	M	Issue No.	1312
LM End	25.24	Issue Type +	En	Location *	LS
Category	Supplemental			GPS Latitude/Longitude	
				Start	End
Item	DWR UCIP Field Study			37.051477 °	37.051477 °
				-120.492650 °	-120.492650 °
DWR ID					
Comment Code					
Inspector Comment					
FS_ID:32789					
DS_ID:19803					
EP_NO: N/A					
Repair Type: Non-Urgent					
Crossing Status: Found					
UCIP Comments: Flapgate propped open during flood season.					
FIELD_STRUCT_DESC: 30-inch C.M. stormdrain pipe through the					
levee, 11.3 feet below the crown. Flap gate on the waterward end.					
Concrete headwall on the landward end. Concrete "U" headwall on the					
waterward end. (USACE-1967). This entry matches the Drainage or					
Irrigation Structure referenced in O&M manual (HLM 25.13).					
FS Date: 3/25/2014

Concrete headwall and flapgate on WS toe.

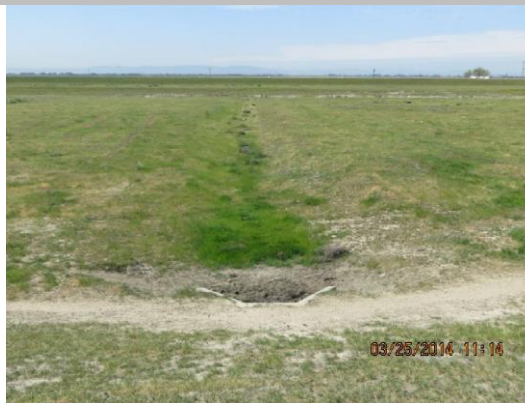
Photo 1 of 2 : UCIP_SP_2016_39625_59316.jpg

Comment Code						
Inspector Comment						
FS_ID:39625 DS_ID:19804 EP_NO: N/A Repair Type: Non-Urgent Crossing Status: Found UCIP Comments: Dense vegetation limits the inspector's visibility to identify signs of pipe failure (leaks) along the landward slope. Recommend removing vegetation along pipe alignment to conduct proper inspection of structure. Sediment buildup in pipe visible from landward side--recommend contacting owner to clear pipe. FIELD_STRUCT_DESC: 30-inch C.M. pipe through the levee, 12.0 feet below the crown. Flap gate on the waterward end. Concrete headwall on the landward end. Concrete "U" headwall on the waterward end. (USACE-1967). This entry matches the Drainage or Irrigation Structure referenced in O&M manual (HLM 25.51). FS Date: 3/25/2014

Concrete headwall on WS toe.

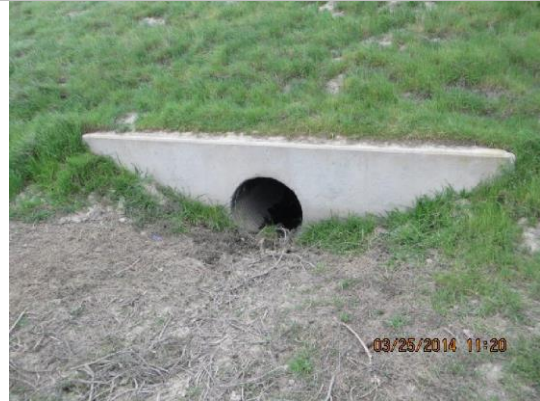
Photo 2 of 2 : UCIP_SP_2016_39626_59320.jpg

LM Start	25.63	Rating **	M	Issue No.	1373 (cont)
LM End	25.63	Issue Type +	En	Location *	LS
Category	Supplemental			GPS Latitude/Longitude	
				Start	End
Item	DWR UCIP Field Study			37.047170 °	37.047170 °
				-120.488222 °	-120.488222 °
DWR ID					
Comment Code					
Inspector Comment					
FS_ID:39626 DS_ID:19805 EP_NO: N/A Repair Type: Non-Urgent Crossing Status: Found UCIP Comments: Sediment buildup in pipe visible from landward side--recommend contacting owner to clear pipe. FIELD_STRUCT_DESC: 30-inch C.M. stormdrain pipe through the levee, 12.1 feet below the crown. Flap gate on the waterward end. Concrete headwall on the landward end. Concrete "U" headwall on the waterward end. (USACE-1967). This entry matches the Drainage or Irrigation Structure referenced in O&M manual (HLM 25.53). FS Date: 3/25/2014

Concrete headwall on LS toe.

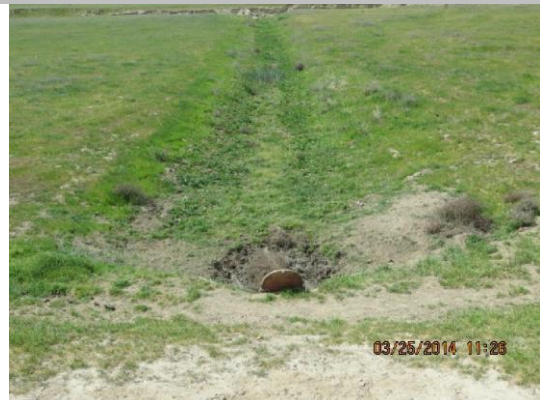
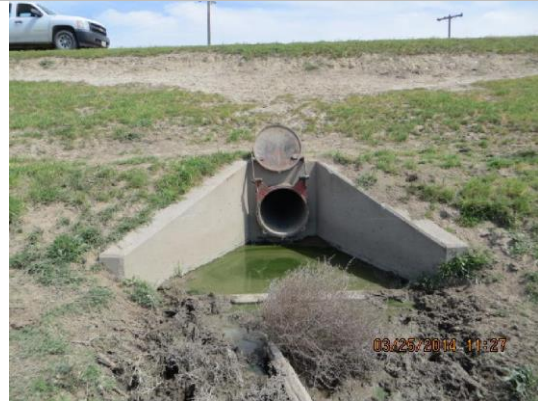
LM Start	26.20	Rating **	M	Issue No.	1374
LM End	26.20	Issue Type +	En	Location *	LS
Category	Supplemental			GPS Latitude/Longitude	
				Start	End
Item	DWR UCIP Field Study			37.040070 °	37.040070 °
				-120.482796 °	-120.482796 °
DWR ID					
Comment Code					
Inspector Comment					
FS_ID:39627 DS_ID:19806 EP_NO: N/A Repair Type: Non-Urgent Crossing Status: Found UCIP Comments: Sediment buildup in pipe visible from landward side--recommend contacting owner to clear pipe. FIELD_STRUCT_DESC: 24-inch C.M. stormdrain pipe through the levee, 10.0 feet below the crown. Flap gate on the waterward end. Concrete headwall on the landward end. Concrete "U" headwall on the waterward end. (USACE-1967). This entry matches the Drainage or Irrigation Structure referenced in O&M manual (HLM 26.11). FS Date: 3/25/2014

Concrete headwall on WS toe.

Flapgate on Concrete headwall at WS toe.

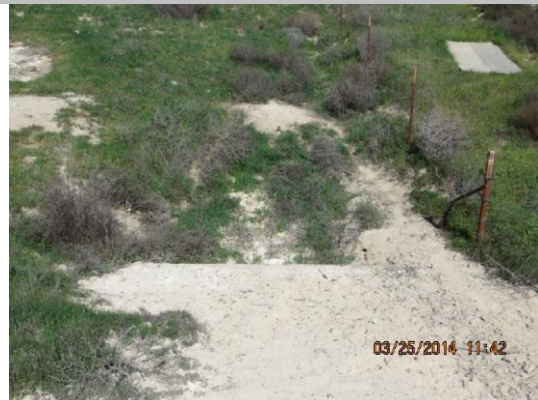
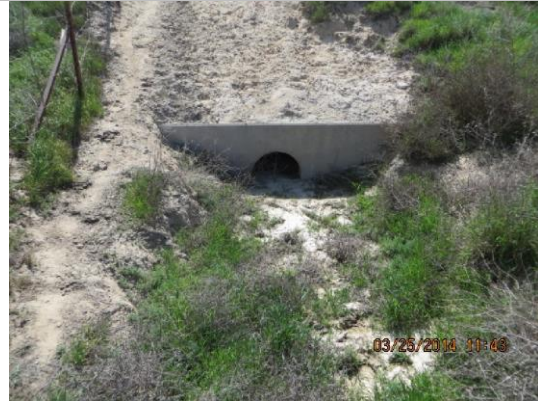
LM Start	26.95	Rating **	M	Issue No.	1375
LM End	26.95	Issue Type +	En	Location *	LS
Category	Supplemental			GPS Latitude/Longitude	
				Start	End
Item	DWR UCIP Field Study			37.032669 °	37.032669 °
				-120.473901 °	-120.473901 °
DWR ID					
Comment Code					
Inspector Comment					
FS_ID:39628 DS_ID:19808 EP_NO: N/A Repair Type: Non-Urgent Crossing Status: Found UCIP Comments: Pipe has heavy silt buildup visible from landward side--recommend contacting owner to clear pipe. FIELD_STRUCT_DESC: 24-inch C.M. stormdrain pipe through the levee, 11.4 feet below the crown. Flap gate on the waterward end. Concrete headwall on the landward end. Concrete "U" headwall on the waterward end. (USACE-1967). This entry matches the Drainage or Irrigation Structure referenced in O&M manual (HLM 26.85). FS Date: 3/25/2014

Concrete headwall on LS toe.

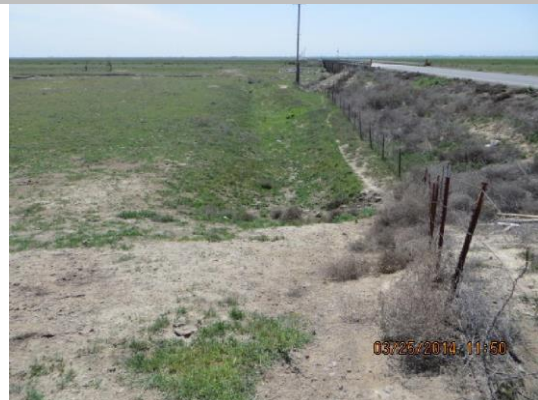
Photo 1 of 2 : UCIP_SP_2016_32806_59353.jpg

LM Start	26.97	Rating **	M	Issue No.	1313
LM End	26.97	Issue Type +	En	Location *	LS
Category	Supplemental			GPS Latitude/Longitude	
				Start	End
Item	DWR UCIP Field Study			37.032680 °	37.032680 °
				-120.473454 °	-120.473454 °
DWR ID					
Comment Code					
Inspector Comment					
FS_ID:32806 DS_ID:19748 EP_NO: N/A Repair Type: Non-Urgent Crossing Status: Found UCIP Comments: Tumble weed buildup at inlet mat create blockage and should be removed. FIELD_STRUCT_DESC: 24-inch C.M. stormdrain pipe through the levee, 11.3 feet below the crown. Flap gate on the waterward end. Concrete headwall on the landward end. Concrete "U" headwall on the waterward end. (USACE-1967). This entry matches the Drainage or Irrigation Structure referenced in O&M manual (HLM 26.87). FS Date: 3/25/2014

Concrete headwall at WS toe.

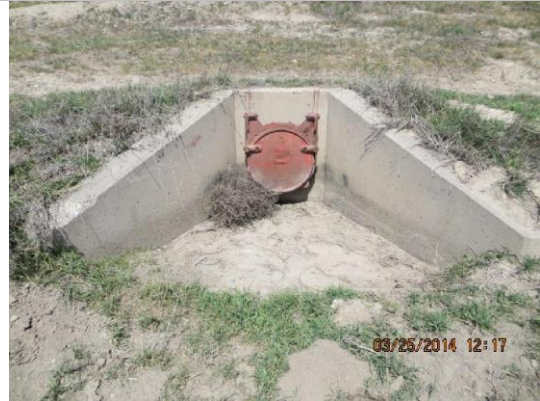
Photo 2 of 2 : UCIP_SP_2016_32823_59383.jpg

LM Start	28.27	Rating **	M	Issue No.	1314 (cont)
LM End	28.27	Issue Type +	En	Location *	LS
Category	Supplemental			GPS Latitude/Longitude	
				Start	End
Item	DWR UCIP Field Study			37.032623 °	37.032623 °
				-120.450108 °	-120.450108 °
DWR ID					
Comment Code					
Inspector Comment					
FS_ID:32823 DS_ID:19750 EP_NO: N/A Repair Type: Non-Urgent Crossing Status: Found UCIP Comments: Animal Burrowing activity at LS toe may undermine headwall. FIELD_STRUCT_DESC: 24-inch C.M. stormdrain pipe through the levee, 10.8 feet below the crown. Flap gate on the waterward end. Concrete headwall on the landward end. Concrete "U" headwall on the waterward end. (USACE-1967). This entry matches the Drainage or Irrigation Structure referenced in O&M manual (HLM 28.17). FS Date: 3/25/2014

Flapgate on Concrete headwall at WS toe.

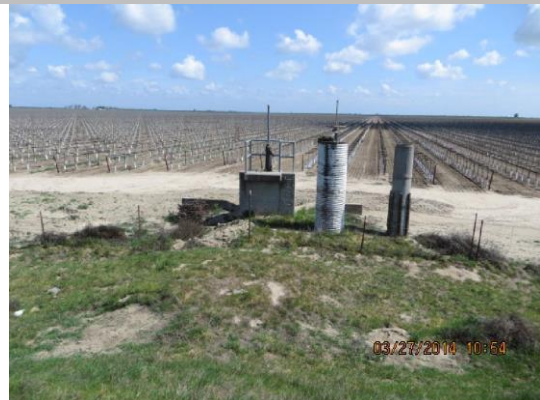
Photo 1 of 2 : UCIP_SP_2016_32830_59410.jpg

Comment Code					
Inspector Comment					
FS_ID:32830 DS_ID:19752 EP_NO: N/A Repair Type: Urgent Crossing Status: Found UCIP Comments: Slide gate will not close due to 24-inch PVC pipe sleeved through pipe. Also slide gate rails rusted beyond use. FIELD_STRUCT_DESC: 48-inch concrete irrigation siphon pipe through the levee, 12.1 feet below the crown. Concrete "U" headwall on inlet structure on the landward end. Slide gate mounted on headwall. 36-inch C.M. pipe riser unit with slide gate, 8.0 feet upstream from siphon on the landward side. 24-inch pipe from this unit enters siphon behind inlet structure. (USACE-1967). This entry matches the Drainage or Irrigation Structure referenced in O&M manual (HLM 28.95). [Rodunder Siphon Structure] FS Date: 3/27/2014

Slide gate mounted to concrete headwall on LS toe.

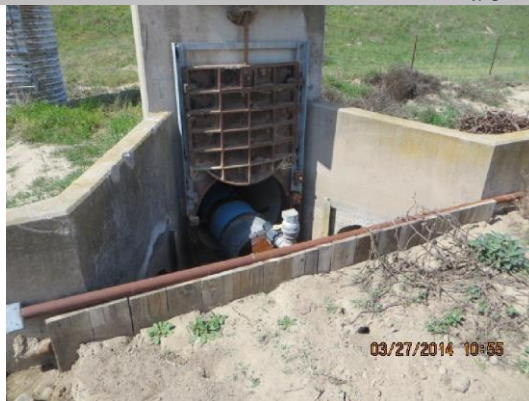
Photo 2 of 2 : UCIP_SP_2016_32830_59409.jpg

Comment Code					
Inspector Comment					
FS_ID:32830 DS_ID:19752 EP_NO: N/A Repair Type: Urgent Crossing Status: Found UCIP Comments: Slide gate will not close due to 24-inch PVC pipe sleeved through pipe. Also slide gate rails rusted beyond use. FIELD_STRUCT_DESC: 48-inch concrete irrigation siphon pipe through the levee, 12.1 feet below the crown. Concrete "U" headwall on inlet structure on the landward end. Slide gate mounted on headwall. 36-inch C.M. pipe riser unit with slide gate, 8.0 feet upstream from siphon on the landward side. 24-inch pipe from this unit enters siphon behind inlet structure. (USACE-1967). This entry matches the Drainage or Irrigation Structure referenced in O&M manual (HLM 28.95). [Rodunder Siphon Structure] FS Date: 3/27/2014

24-inch PVC pipe sleeved through 48-inch concrete pipe.

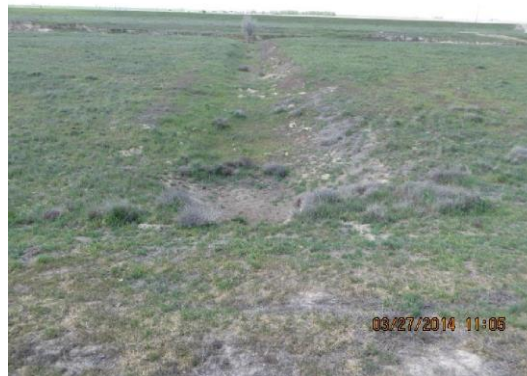
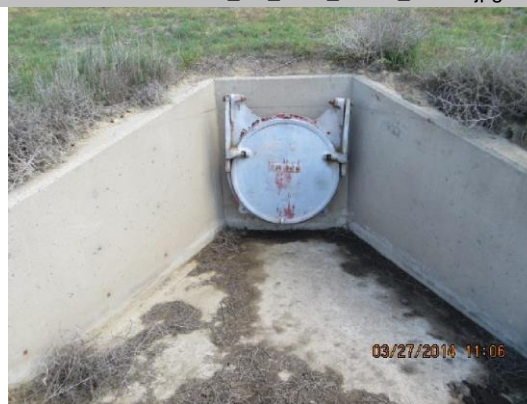
Comment Code					
Inspector Comment					
FS_ID:39884 DS_ID:19753 EP_NO: N/A Repair Type: Non-Urgent Crossing Status: Found UCIP Comments: Dense vegetation limits the inspector's visibility to identify signs of pipe failure (leaks) along the landward slope. Recommend removing vegetation along pipe alignment to conduct proper inspection of structure. Sediment buildup in pipe visible from landward side--recommend contacting owner to clear pipe. FIELD_STRUCT_DESC: 36-inch C.M. pipe through the levee, 10.2 feet below the crown. Flap gate on the waterward end. Concrete headwall on the landward end. Concrete "U" headwall on the waterward end. (USACE-1967). This entry matches the Drainage or Irrigation Structure referenced in O&M manual (HLM 29.49). FS Date: 3/27/2014

Concrete headwall on WS toe.

Flapgate on Concrete headwall at WS toe.

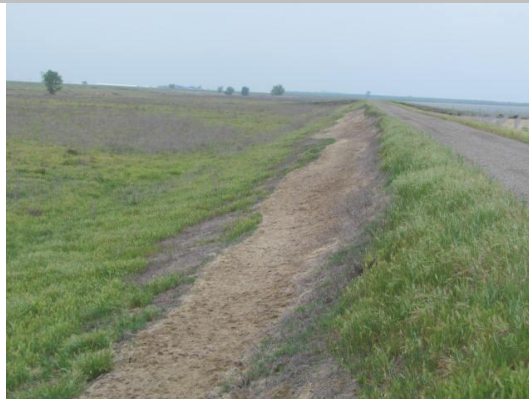
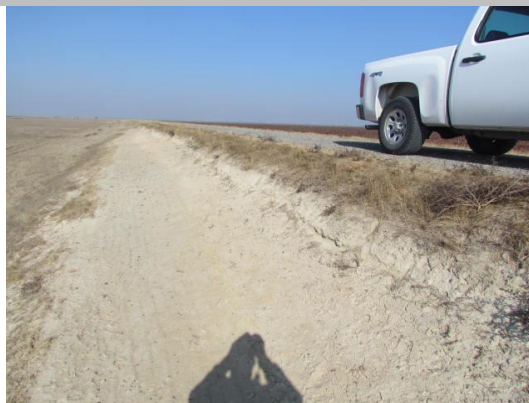
LM Start	29.68	Rating **	M	Issue No.	171
LM End	29.80	Issue Type +	Ma	Location *	LS
Category	Earthen Levee			GPS Latitude/Longitude	
				Start	End
Item	Erosion / Bank Caving			37.020272 °	37.018712 °
				-120.433737 °	-120.432682 °
DWR ID	DWR_NA0010_05_s _ 2014_171				
Comment Code					
E1 : Note and monitor erosion site.					
Inspector Comment					
Waterside erosion caused by livestock.

Looking south at erosion caused by livestock on landside slope.

Looking south at livestock erosion on landward slope.

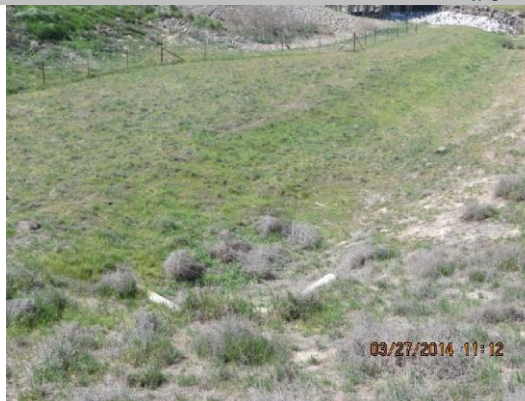
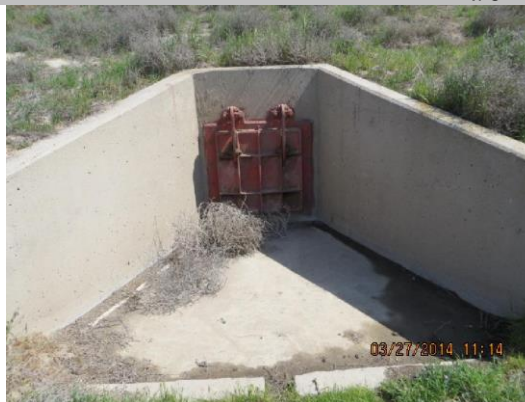
Comment Code					
Inspector Comment					
FS_ID:39631 DS_ID:19754 EP_NO: N/A Repair Type: Non-Urgent Crossing Status: Found UCIP Comments: Dense vegetation limits the inspector's visibility to identify signs of pipe failure (leaks) along the landward slope. Recommend removing vegetation along pipe alignment to conduct proper inspection of structure. FIELD_STRUCT_DESC: 30-inch square R.C.B.C. through the levee, 12.0 feet below the crown. Concrete "U" headwall on the waterward end. Flap gate on the waterward end. Concrete headwall on the landward end. (USACE-1967). This entry matches the Drainage or Irrigation Structure referenced in O&M manual (HLM 29.72). FS Date: 3/27/2014

Concrete headwall on WS toe.

Flapgate on Concrete headwall at WS toe.
