**Flood Control Project Maintenance
Levee Inspections****LMA District Cover Sheet****Spring 2016 Levee Inspection Results****Lower San Joaquin Levee District**

Spring 2016 Levee Inspection Results

Lower San Joaquin Levee District

Waterway			Bank	Unit Miles
Unit No. 01 San Joaquin River			Right	22.52
	Spring (March - May)	Summer (June - August)	(September - November) Fall	Winter (December - February)
Unit Maintenance Rating (Fall Only)				
Date of Inspection	5/16/2016 - 5/19/2016			
DWR Inspector	Richard Willoughby			
Accompanied By

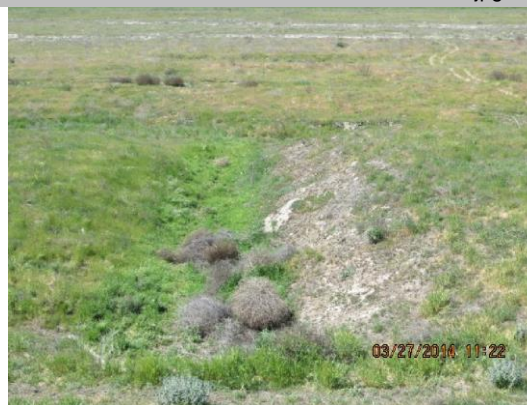
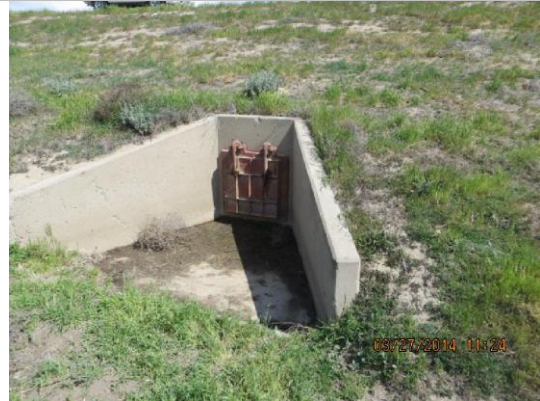
Comment Code					
Inspector Comment					
FS_ID:39632 DS_ID:19696 EP_NO: N/A Repair Type: Non-Urgent Crossing Status: Found UCIP Comments: Dense vegetation limits the inspector's visibility to identify signs of pipe failure (leaks) along the landward slope. Recommend removing vegetation along pipe alignment to conduct proper inspection of structure. FIELD_STRUCT_DESC: 30-inch square stormdrain R.C.B.C. through the levee, 13.1 feet below the crown. Concrete "U", headwall on the waterward end. Flap gate on the waterward end. Concrete headwall on the landward end. (USACE-1967). This entry matches the Drainage or Irrigation Structure referenced in O&M manual (HLM 30.04). FS Date: 3/27/2014

Concrete headwall on WS toe.

Flapgate on Concrete headwall at WS toe.

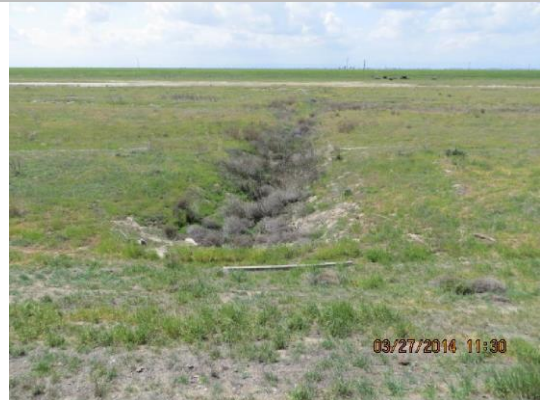
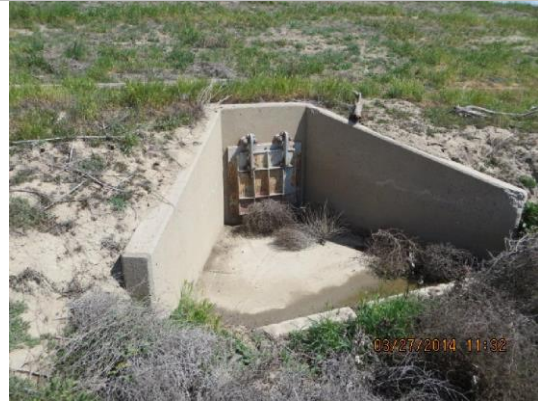
Comment Code					
Inspector Comment					
FS_ID:39633 DS_ID:19697 EP_NO: N/A Repair Type: Non-Urgent Crossing Status: Found UCIP Comments: Some debris buildup at LS toe. Dense vegetation limits the inspector's visibility to identify signs of pipe failure (leaks) along the landward slope. Recommend removing vegetation along pipe alignment to conduct proper inspection of structure. FIELD_STRUCT_DESC: 30-inch square R.C.B.C. stormdrain through the levee, 13.3 feet below the crown. Concrete "U" headwall on the waterward end. Flap gate on the waterward end. Concrete headwall on the landward end. (USACE-1967). This entry matches the Drainage or Irrigation Structure referenced in O&M manual (HLM 30.96). FS Date: 3/27/2014

Concrete headwall on WS toe.

Flapgate on Concrete headwall at WS toe.

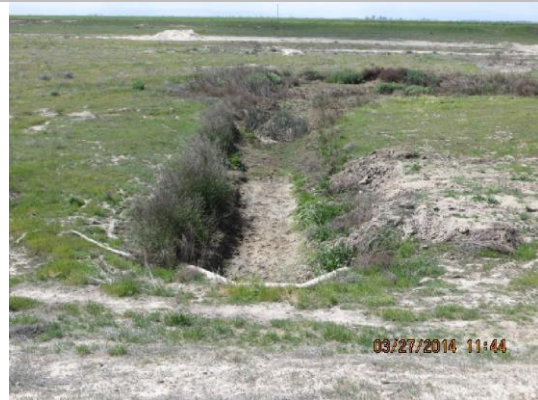
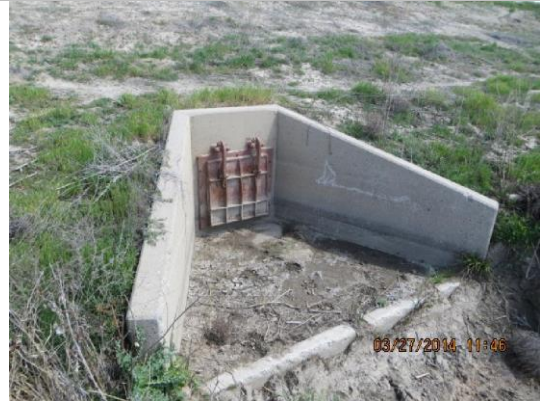
Comment Code					
Inspector Comment					
FS_ID:39643 DS_ID:19698 EP_NO: N/A Repair Type: Non-Urgent Crossing Status: Found UCIP Comments: Excess vegetation buildup at inlet on LS toe. Dense vegetation limits the inspector's visibility to identify signs of pipe failure (leaks) along the landward slope. Recommend removing vegetation along pipe alignment to conduct proper inspection of structure. FIELD_STRUCT_DESC: 30-inch square R.C.B.C. stormdrain through levee, 13.4 feet below crown. Concrete "U" headwall on waterward end. Flap gate on waterward end. Concrete headwall on landward end. (USACE-1967). This entry matches the Drainage or Irrigation Structure referenced in O&M manual (HLM 31.19). FS Date: 3/27/2014

Concrete headwall on WS toe.

Flapgate at concrete headwall on WS toe.

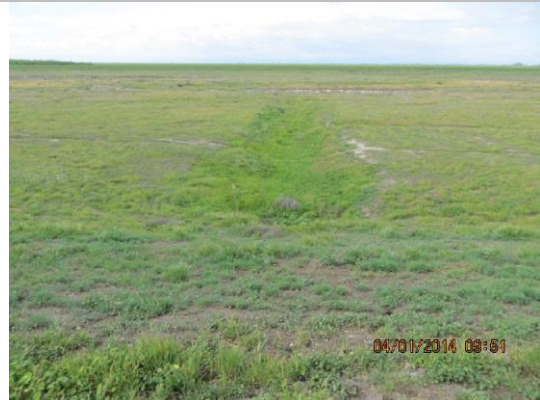
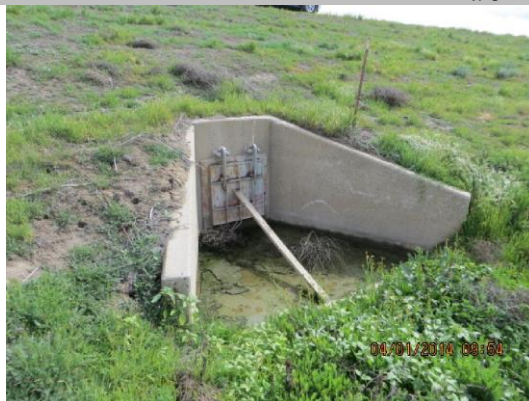
Comment Code					
Inspector Comment					
FS_ID:39645 DS_ID:19700 EP_NO: N/A Repair Type: Non-Urgent Crossing Status: Found UCIP Comments: Dense vegetation limits the inspector's visibility to identify signs of pipe failure (leaks) along the landward slope. Recommend removing vegetation along pipe alignment to conduct proper inspection of structure. FIELD_STRUCT_DESC: 30-inch square R.C.B.C. through the levee, 13.0 feet below the crown. Concrete "U" headwall on the waterward end. Flap gate on the waterward end. Concrete headwall on the landward end with flashboard attachment. (USACE-1967). This entry matches the Drainage or Irrigation Structure referenced in O&M manual (HLM 31.71). FS Date: 4/1/2014

Concrete headwall at channel on WS toe.

Flapgate on Concrete headwall at channel on WS toe.

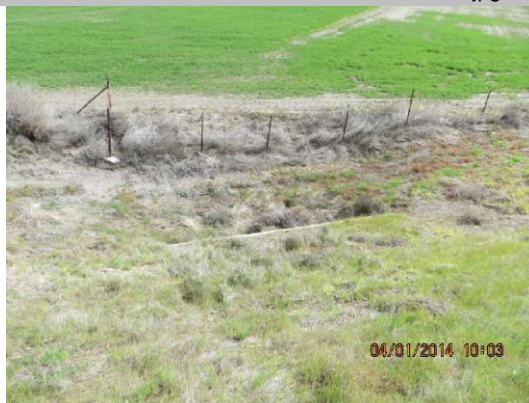
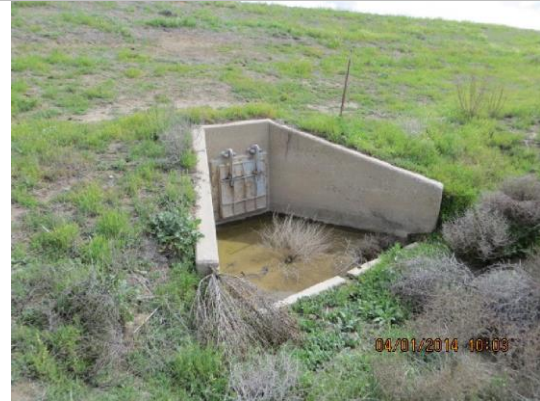
LM Start	32.32	Rating **	M	Issue No.	1346
LM End	32.32	Issue Type +	En	Location *	LS
Category	Supplemental			GPS Latitude/Longitude	
				Start	End
Item	DWR UCIP Field Study			36.989435 °	36.989435 °
				-120.402626 °	-120.402626 °
DWR ID					
Comment Code					
Inspector Comment					
FS_ID:39646 DS_ID:19701 EP_NO: N/A Repair Type: Non-Urgent Crossing Status: Found UCIP Comments: Some silt buildup inside culvert. FIELD_STRUCT_DESC: 30-inch square R.C.B.C. through the levee, 14.2 feet below the crown. Concrete "U" headwall on the waterward end. Flap gate on the waterward end. Concrete headwall on the landward end with flashboard attachment. (USACE-1967). This entry matches the Drainage or Irrigation Structure referenced in O&M manual (HLM 32.22). FS Date: 4/1/2014

Concrete headwall at inlet on LS toe.

Flapgate on Concrete headwall at WS toe.

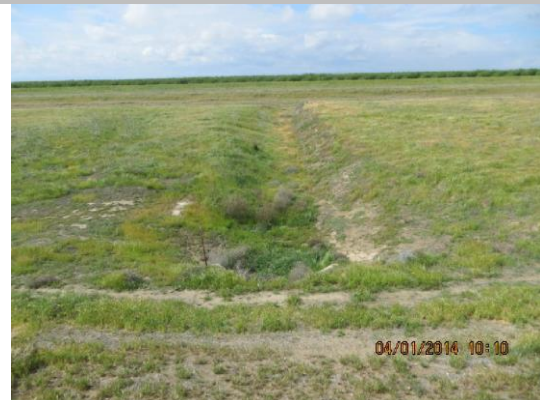
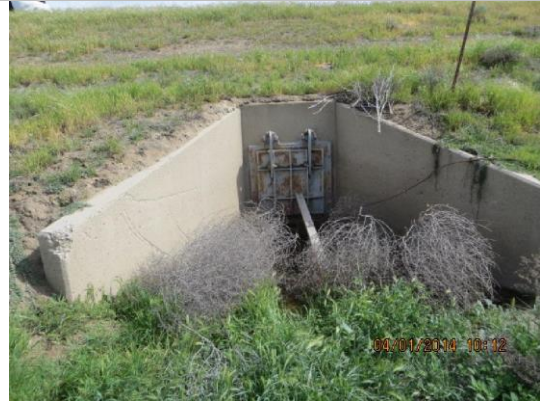
Comment Code					
Inspector Comment					
FS_ID:39647					
DS_ID:19702					
EP_NO: N/A					
Repair Type: Non-Urgent					
Crossing Status: Found					
UCIP Comments: Dense vegetation limits the inspector's visibility to identify signs of pipe failure (leaks) along the landward slope. Recommend removing vegetation along pipe alignment to conduct proper inspection of structure. Debris buildup blocking landward headwall--recommend contacting owner to clear debris.					
FIELD_STRUCT_DESC: 30-inch square R.C.B.C. through the levee, 12.2 feet below the crown. Concrete "U" headwall on the waterward end. Flap gate on the waterward end. Concrete headwall on the landward end. (USACE-1967). This entry matches the Drainage or Irrigation Structure referenced in O&M manual (HLM 33.01).					
FS Date: 4/1/2014

Concrete headwall at WS toe.

Flapgate on Concrete headwall at WS toe.

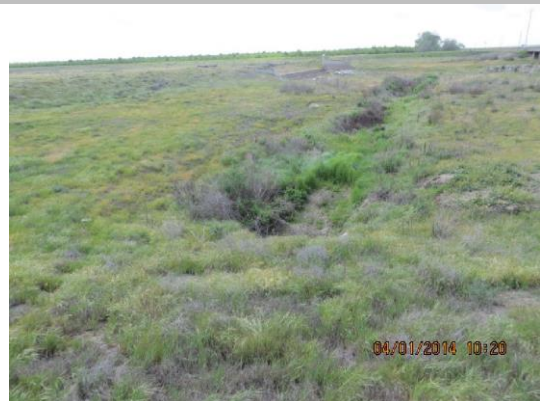
Photo 1 of 2 : UCIP_SP_2016_39648_59701.jpg

Comment Code						
Inspector Comment						
FS_ID:39648 DS_ID:19703 EP_NO: N/A Repair Type: Non-Urgent Crossing Status: Found UCIP Comments: Dense vegetation limits the inspector's visibility to identify signs of pipe failure (leaks) along the slopes. Recommend removing vegetation along pipe alignment to conduct proper inspection of structure. FIELD_STRUCT_DESC: 30-inch square R.C.B.C. through the levee, 13.9 feet below the crown. Concrete "U" headwall on the waterward end. Flap gate on the waterward end. Concrete headwall on the landward end. (USACE-1967). This entry matches the Drainage or Irrigation Structure referenced in O&M manual (HLM 33.72). FS Date: 4/1/2014

Concrete headwall at WS toe.

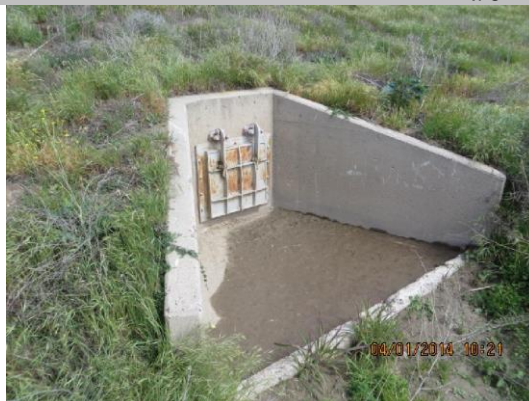
Photo 2 of 2 : UCIP_SP_2016_39648_59700.jpg

Item	DWR UCIP Field Study			36.976808 °	36.976808 °	
				-120.382593 °	-120.382593 °	
DWR ID						
Comment Code						
Inspector Comment						
FS_ID:39648						
DS_ID:19703						
EP_NO: N/A						
Repair Type: Non-Urgent						
Crossing Status: Found						
UCIP Comments: Dense vegetation limits the inspector's visibility to identify signs of pipe failure (leaks) along the slopes. Recommend removing vegetation along pipe alignment to conduct proper inspection of structure.						
FIELD_STRUCT_DESC: 30-inch square R.C.B.C. through the levee, 13.9 feet below the crown. Concrete "U" headwall on the waterward end. Flap gate on the waterward end. Concrete headwall on the landward end. (USACE-1967). This entry matches the Drainage or Irrigation Structure referenced in O&M manual (HLM 33.72).						
FS Date: 4/1/2014

Flapgate on Concrete headwall at WS toe.

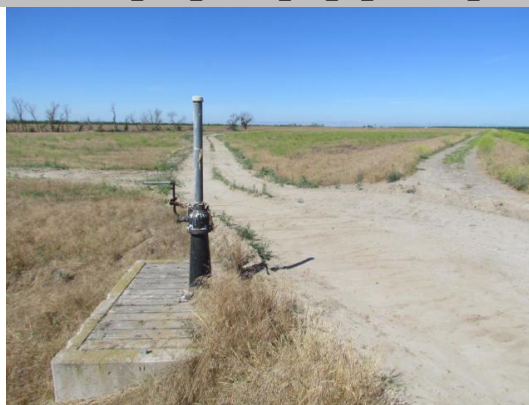
Photo 1 of 4 : SP_2016_NA0010_123_11_20160523_00209.jpg

LM Start	34.61	Rating **	M	Issue No.	11
LM End	34.61	Issue Type +	En	Location *	WS
Category	Earthen Levee			GPS Latitude/Longitude	
				Start	End
Item	Encroachments			36.978555 °	36.978555 °
				-120.368467 °	-120.368467 °
DWR ID	DWR_NA0010_05_s_2012_11				
Comment Code					
RA : Ramp					
Inspector Comment					
Unauthorized ramp on waterside slope. Landowner cut unauthorized ramp on waterside slope and levee crown.

Looking west at ramp on waterward slope.

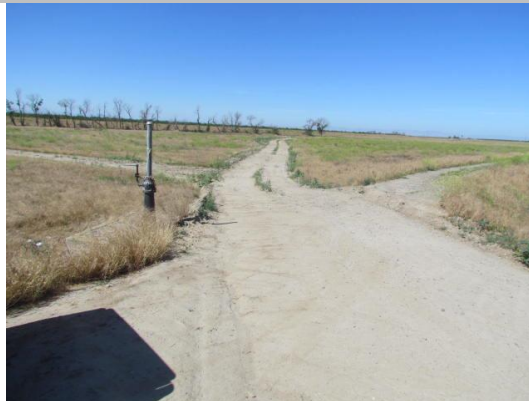
Photo 2 of 4 : SP_2016_NA0010_123_11_20160523_00208.jpg

Looking northwest at cut on levee crown.

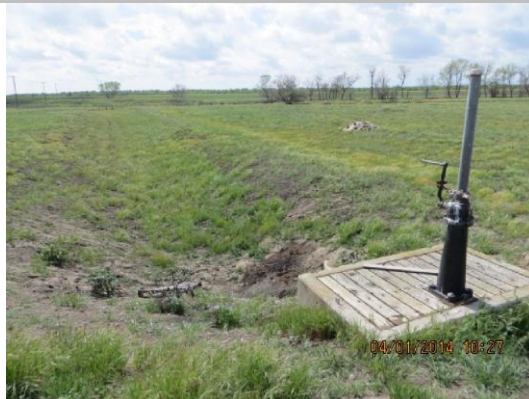
Photo 1 of 2 : UCIP_SP_2016_39649_59706.jpg

Comment Code					
Inspector Comment					
FS_ID:39649 DS_ID:19755 EP_NO: N/A Repair Type: Non-Urgent Crossing Status: Found UCIP Comments: Dense vegetation limits the inspector's visibility to identify signs of pipe failure (leaks) along the landward slope. Recommend removing vegetation along pipe alignment to conduct proper inspection of structure. Debris buildup visible on waterward headwall--recommend contacting owner to clear pipe. FIELD_STRUCT_DESC: 36-inch square R.C.B.C. through the levee, 9.7 feet below the crown. Slide gate in 56"X91" concrete riser unit on the waterward slope. Concrete "U" headwalls on both ends. Landside channel cobble revetted for 8.0 feet. (USACE-1967). [Chowchilla Canal Irrigation Structure] This entry matches the Drainage or Irrigation Structure referenced in O&M manual (HLM 34.51). FS Date: 4/1/2014

Slide gate in concrete riser on WS shoulder.

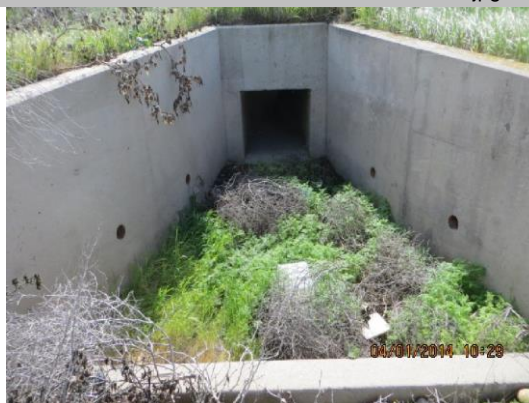
Photo 2 of 2 : UCIP_SP_2016_39649_59704.jpg

Concrete headwall at LS toe.

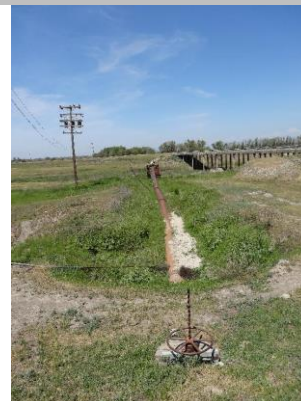
Photo 1 of 2 : UCIP_SP_2016_39463_66341.jpg

LM Start	0.66	Rating **	M	Issue No.	1239
LM End	0.66	Issue Type +	En	Location *	WS
Category	Supplemental			GPS Latitude/Longitude	
				Start	End
Item	DWR UCIP Field Study			37.271444 °	37.271444 °
				-120.815835 °	-120.815835 °
DWR ID					
Comment Code					
Inspector Comment					
FS_ID:39463 DS_ID:19815 EP_NO: N/A Repair Type: Non-Urgent Crossing Status: Found UCIP Comments: Need to contact owner. Sediment buildup on landward side. Recommend removing sediment buildup on landward toe. FIELD_STRUCT_DESC: 24-inch CM pipe through levee, 7.2 feet below crown. Slide gate inside 36-inch CM pipe riser in the waterward slope. Pump on concrete structure in channel. Concrete headwall on both ends. (USACE-1967). This entry matches the Drainage or Irrigation Structure referenced in O&M manual (HLM 0.74). FS Date: 4/18/2014

View of waterward side.

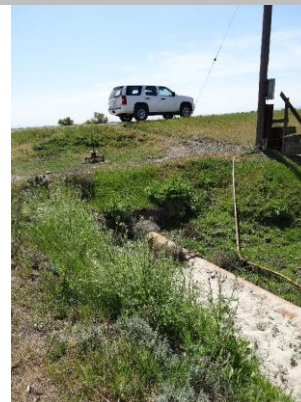
Photo 2 of 2 : UCIP_SP_2016_39463_66343.jpg

View of slope on waterward side.

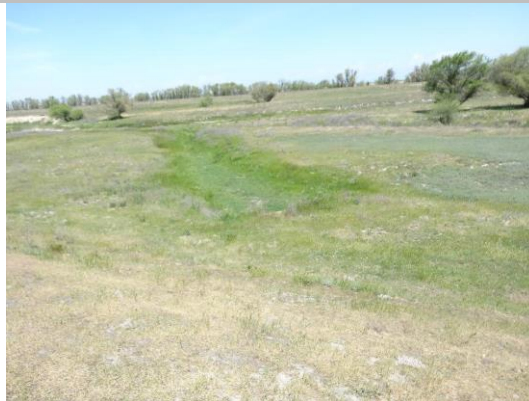
Photo 1 of 2 : UCIP_SP_2016_36565_66346.jpg

LM Start	0.78	Rating **	M	Issue No.	1228
LM End	0.78	Issue Type +	En	Location *	WS
Category	Supplemental			GPS Latitude/Longitude	
				Start	End
Item	DWR UCIP Field Study			37.270460 °	37.270460 °
				-120.814290 °	-120.814290 °
DWR ID					
Comment Code					
Inspector Comment					
FS_ID:36565 DS_ID:19816 EP_NO: N/A Repair Type: Non-Urgent Crossing Status: Found UCIP Comments: Landward side blocked--need to contact owner to determine status of crossing. FIELD_STRUCT_DESC: 24-inch CM pipe through levee, 16.2 feet below crown. Flap gate on the waterward end. Concrete "U" headwall on both ends. (USACE-1967). This entry matches the Drainage or Irrigation Structure referenced in O&M manual (HLM 0.86). FS Date: 4/18/2014

Overview of waterward side.

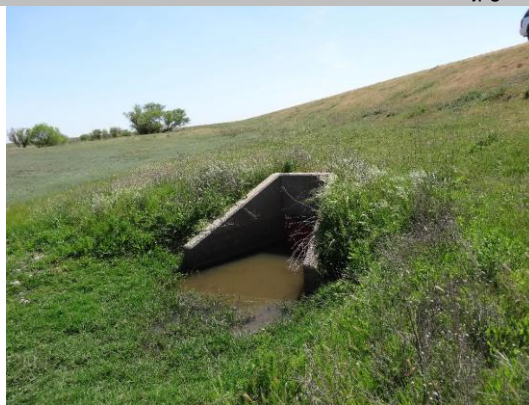
Photo 2 of 2 : UCIP_SP_2016_36565_66345.jpg

Concrete structure located on waterward toe.

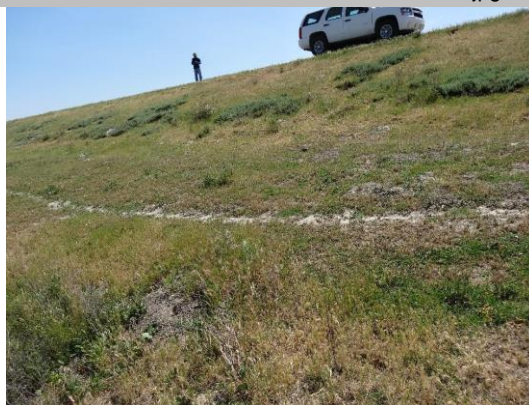
Photo 1 of 2 : UCIP_SP_2016_36566_66348.jpg

LM Start	1.87	Rating **	M	Issue No.	1229
LM End	1.87	Issue Type +	En	Location *	LS
Category	Supplemental			GPS Latitude/Longitude	
				Start	End
Item	DWR UCIP Field Study			37.259312 °	37.259312 °
				-120.802863 °	-120.802863 °
DWR ID					
Comment Code					
Inspector Comment					
FS_ID:36566 DS_ID:19817 EP_NO: N/A Repair Type: Non-Urgent Crossing Status: Found UCIP Comments: No access was available to landward side due to fence. Recommend removing some of the vegetation on waterward toe. FIELD_STRUCT_DESC: 24-inch CM pipe through levee, 13.5 feet below crown. Flap gate on the waterward end. Concrete headwall at both ends. (USACE-1967). This entry matches the Drainage or Irrigation Structure referenced in O&M manual (HLM 1.95). FS Date: 4/18/2014

View of waterward side.

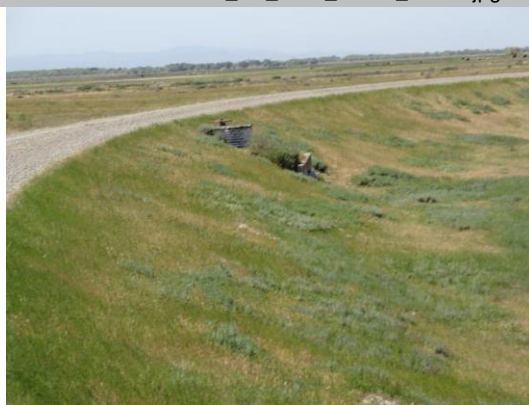
Photo 1 of 2 : UCIP_SP_2016_39464_66354.jpg

LM Start	2.53	Rating **	M	Issue No.	1240
LM End	2.53	Issue Type +	En	Location *	LS
Category	Supplemental			GPS Latitude/Longitude	
				Start	End
Item	DWR UCIP Field Study			37.252948 °	37.252948 °
				-120.794352 °	-120.794352 °
DWR ID					
Comment Code					
Inspector Comment					
FS_ID:39464 DS_ID:19818 EP_NO: N/A Repair Type: Non-Urgent Crossing Status: Found UCIP Comments: Need to contact owner. Sediment buildup in pipe visible on landward side. FIELD_STRUCT_DESC: 36-inch CM pipe through levee, 6.9 feet below crown. Slide gate in 48-inch CM pipe riser in the waterward slope. Concrete headwall on both ends. (USACE-1967). This entry matches the Drainage or Irrigation Structure referenced in O&M manual (HLM 2.61). FS Date: 4/18/2014

View of waterward side.

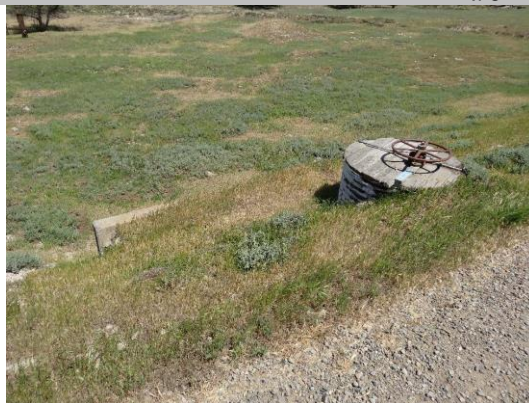
Photo 2 of 2 : UCIP_SP_2016_39464_66357.jpg

LM Start	2.53	Rating **	M	Issue No.	1240 (cont)	
LM End	2.53	Issue Type +	En	Location *	LS	
Category	Supplemental			GPS Latitude/Longitude		
				Start		End
Item	DWR UCIP Field Study			37.252948 °	37.252948 °	
				-120.794352 °	-120.794352 °	
DWR ID						
Comment Code						
Inspector Comment						
FS_ID:39464 DS_ID:19818 EP_NO: N/A Repair Type: Non-Urgent Crossing Status: Found UCIP Comments: Need to contact owner. Sediment buildup in pipe visible on landward side. FIELD_STRUCT_DESC: 36-inch CM pipe through levee, 6.9 feet below crown. Slide gate in 48-inch CM pipe riser in the waterward slope. Concrete headwall on both ends. (USACE-1967). This entry matches the Drainage or Irrigation Structure referenced in O&M manual (HLM 2.61). FS Date: 4/18/2014

View of waterward side.

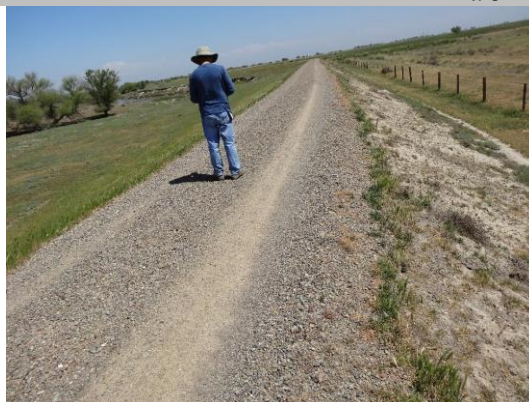
Photo 1 of 2 : UCIP_SP_2016_36568_66362.jpg

LM Start	2.57	Rating **	M	Issue No.	1230
LM End	2.57	Issue Type +	En	Location *	LS
Category	Supplemental			GPS Latitude/Longitude	
				Start	End
Item	DWR UCIP Field Study			37.252743 °	37.252743 °
				-120.793756 °	-120.793756 °
DWR ID					
Comment Code					
Inspector Comment					
FS_ID:36568 DS_ID:19819 EP_NO: N/A Repair Type: Non-Urgent Crossing Status: Found UCIP Comments: Dense vegetation limits the inspector's visibility to identify signs of pipe condition on landward toe--headwall blocked by dense vegetation. Recommend removing vegetation from landward toe. FIELD_STRUCT_DESC: 24-inch CM pipe through levee, 9.2 feet below crown. Flap gate on the waterward end. Concrete headwall on both ends. (USACE-1967). This entry matches the Drainage or Irrigation Structure referenced in O&M manual (HLM 2.65). FS Date: 4/18/2014

Overview of levee crown at crossing.

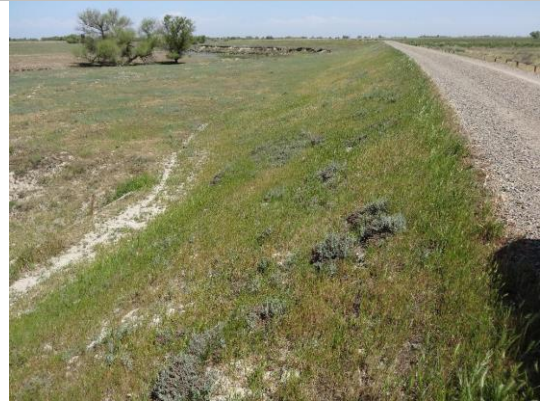
Photo 2 of 2 : UCIP_SP_2016_36568_66360.jpg

LM Start	2.57	Rating **	M	Issue No.	1230 (cont)
LM End	2.57	Issue Type +	En	Location *	LS
Category	Supplemental			GPS Latitude/Longitude	
				Start	End
Item	DWR UCIP Field Study			37.252743 °	37.252743 °
				-120.793756 °	-120.793756 °
DWR ID					
Comment Code					
Inspector Comment					
FS_ID:36568 DS_ID:19819 EP_NO: N/A Repair Type: Non-Urgent Crossing Status: Found UCIP Comments: Dense vegetation limits the inspector's visibility to identify signs of pipe condition on landward toe--headwall blocked by dense vegetation. Recommend removing vegetation from landward toe. FIELD_STRUCT_DESC: 24-inch CM pipe through levee, 9.2 feet below crown. Flap gate on the waterward end. Concrete headwall on both ends. (USACE-1967). This entry matches the Drainage or Irrigation Structure referenced in O&M manual (HLM 2.65). FS Date: 4/18/2014

View of waterward side.

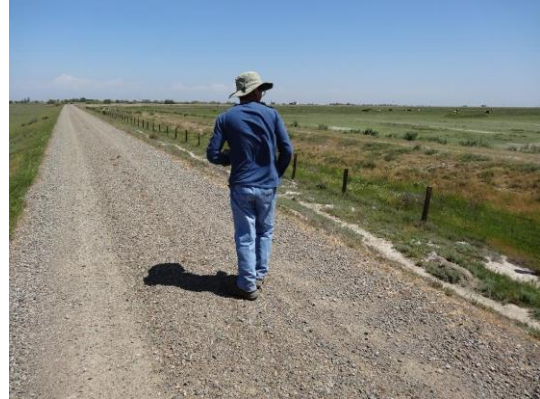
Photo 2 of 2 : UCIP_SP_2016_36569_66368.jpg

LM Start	2.77	Rating **	M	Issue No.	1231 (cont)	
LM End	2.77	Issue Type +	En	Location *	LS	
Category	Supplemental			GPS Latitude/Longitude		
				Start	End	
Item	DWR UCIP Field Study			37.253020 °	37.253020 °	
				-120.790219 °	-120.790219 °	
DWR ID						
Comment Code						
Inspector Comment						
FS_ID:36569 DS_ID:19820 EP_NO: N/A Repair Type: Non-Urgent Crossing Status: Found UCIP Comments: Dense vegetation limits the inspector's visibility to identify signs of pipe condition on landward toe--headwall blocked by dense vegetation. Recommend removing vegetation from landward toe. FIELD_STRUCT_DESC: 24-inch CM pipe through levee, 10.5 feet below crown. Flap gate on the waterward end. Concrete headwall on both ends. (USACE-1967). This entry matches the Drainage or Irrigation Structure referenced in O&M manual (HLM 2.85). FS Date: 4/18/2014

Overview of levee crown at crossing.

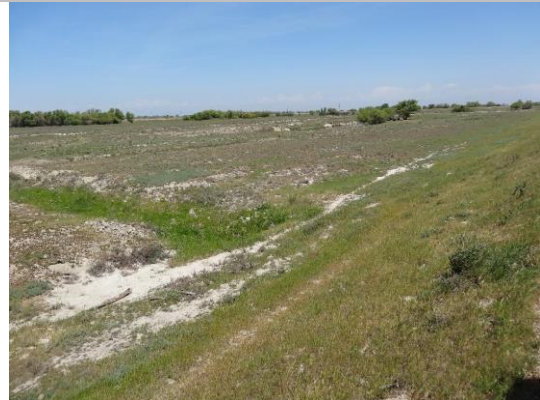
Photo 1 of 2 : UCIP_SP_2016_36583_66381.jpg

LM Start	3.01	Rating **	M	Issue No.	1232
LM End	3.01	Issue Type +	En	Location *	LS
Category	Supplemental			GPS Latitude/Longitude	
				Start	End
Item	DWR UCIP Field Study			37.253811 °	37.253811 °
				-120.786059 °	-120.786059 °
DWR ID					
Comment Code					
Inspector Comment					
FS_ID:36583					
DS_ID:19821					
EP_NO: N/A					
Repair Type: Non-Urgent					
Crossing Status: Found					
UCIP Comments: Dense vegetation limits the inspector's visibility to identify signs of pipe condition on landward toe--headwall blocked by dense vegetation. Recommend removing vegetation from landward toe.					
FIELD_STRUCT_DESC: 24 inch CM pipe through levee, 11.2 feet below crown. Flap gate on the waterward end. Concrete headwall on both ends. (USACE-1967). This entry matches the Drainage or Irrigation Structure referenced in O&M manual (HLM 3.09).					
FS Date: 4/18/2014

View of waterward side.

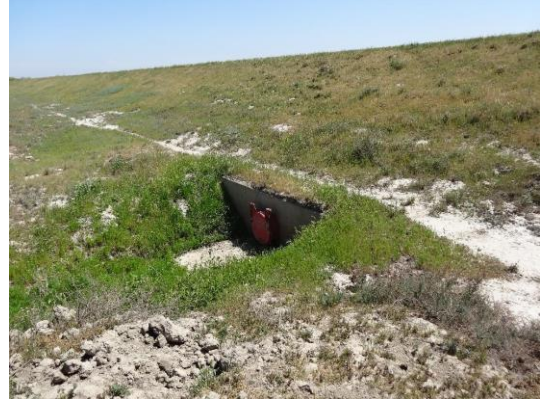
Photo 2 of 2 : UCIP_SP_2016_36583_66380.jpg

LM Start	3.01	Rating **	M	Issue No.	1232 (cont)	
LM End	3.01	Issue Type +	En	Location *	LS	
Category	Supplemental			GPS Latitude/Longitude		
				Start	End	
Item	DWR UCIP Field Study			37.253811 °	37.253811 °	
				-120.786059 °	-120.786059 °	
DWR ID						
Comment Code						
Inspector Comment						
FS_ID:36583						
DS_ID:19821						
EP_NO: N/A						
Repair Type: Non-Urgent						
Crossing Status: Found						
UCIP Comments: Dense vegetation limits the inspector's visibility to identify signs of pipe condition on landward toe--headwall blocked by dense vegetation. Recommend removing vegetation from landward toe.						
FIELD_STRUCT_DESC: 24 inch CM pipe through levee, 11.2 feet below crown. Flap gate on the waterward end. Concrete headwall on both ends. (USACE-1967). This entry matches the Drainage or Irrigation Structure referenced in O&M manual (HLM 3.09).						
FS Date: 4/18/2014

Flap gate and concrete headwall visible on waterward side.

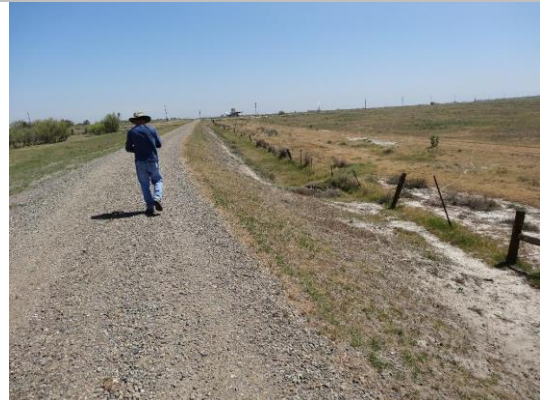
Photo 1 of 2 : UCIP_SP_2016_36584_66384.jpg

LM Start	3.21	Rating **	M	Issue No.	1233
LM End	3.21	Issue Type +	En	Location *	LS
Category	Supplemental			GPS Latitude/Longitude	
				Start	End
Item	DWR UCIP Field Study			37.253513 °	37.253513 °
				-120.782509 °	-120.782509 °
DWR ID					
Comment Code					
Inspector Comment					
FS_ID:36584 DS_ID:19822 EP_NO: N/A Repair Type: Non-Urgent Crossing Status: Found UCIP Comments: Dense vegetation limits the inspector's visibility to identify signs of pipe condition on waterward slope and landward toe (headwall blocked by dense vegetation). Recommend removing vegetation from landward toe. FIELD_STRUCT_DESC: 24-inch CM pipe through levee, 10.4 feet below crown. Flap gate on the waterward end. Concrete headwall on both ends. (USACE-1967). This entry matches the Drainage or Irrigation Structure referenced in O&M manual (HLM 3.29). FS Date: 4/18/2014

Overview of levee crown and landward side.

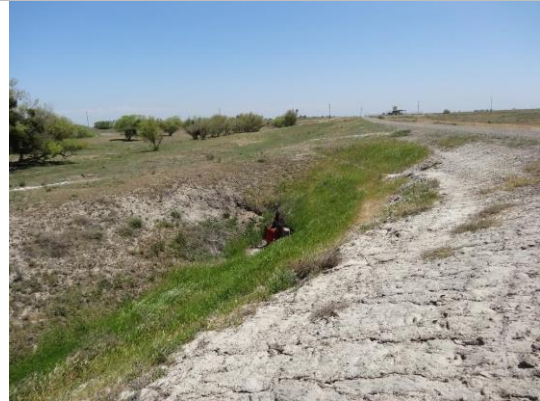
Photo 2 of 2 : UCIP_SP_2016_36584_66386.jpg

LM Start	3.21	Rating **	M	Issue No.	1233 (cont)
LM End	3.21	Issue Type +	En	Location *	LS
Category	Supplemental			GPS Latitude/Longitude	
				Start	End
Item	DWR UCIP Field Study			37.253513 °	37.253513 °
				-120.782509 °	-120.782509 °
DWR ID					
Comment Code					
Inspector Comment					
FS_ID:36584 DS_ID:19822 EP_NO: N/A Repair Type: Non-Urgent Crossing Status: Found UCIP Comments: Dense vegetation limits the inspector's visibility to identify signs of pipe condition on waterward slope and landward toe (headwall blocked by dense vegetation). Recommend removing vegetation from landward toe. FIELD_STRUCT_DESC: 24-inch CM pipe through levee, 10.4 feet below crown. Flap gate on the waterward end. Concrete headwall on both ends. (USACE-1967). This entry matches the Drainage or Irrigation Structure referenced in O&M manual (HLM 3.29). FS Date: 4/18/2014

View of waterward side.

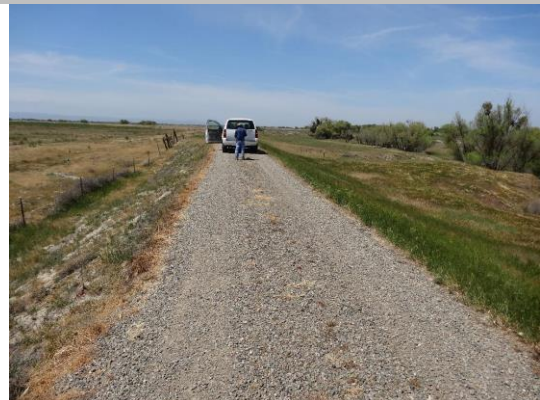
Photo 1 of 2 : UCIP_SP_2016_36585_66389.jpg

Comment Code					
Inspector Comment					
FS_ID:36585 DS_ID:19823 EP_NO: N/A Repair Type: Non-Urgent Crossing Status: Found UCIP Comments: Alignment of crossing unknown--altered crossing. No headwall found on landward side only siphon breaker found a short distance from landward toe. Tall grass observed on waterward slope and some burrow activity also noticed. Need to contact owner to determine alignment of crossing and status of crossing. FIELD_STRUCT_DESC: 36-inch CM pipe through levee, 15.7 feet below crown. Flap gate on the waterward end. Concrete "U" headwall on both ends. BM stamped 9770-152 on top of the headwall on the waterward side. (USACE-1967). This entry matches the Drainage or Irrigation Structure referenced in O&M manual (HLM 3.43). FS Date: 4/18/2014

Overview of levee crown at crossing.

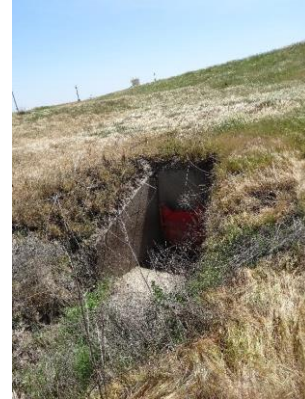
Photo 2 of 2 : UCIP_SP_2016_36585_66390.jpg

Comment Code					
Inspector Comment					
FS_ID:36585 DS_ID:19823 EP_NO: N/A Repair Type: Non-Urgent Crossing Status: Found UCIP Comments: Alignment of crossing unknown--altered crossing. No headwall found on landward side only siphon breaker found a short distance from landward toe. Tall grass observed on waterward slope and some burrow activity also noticed. Need to contact owner to determine alignment of crossing and status of crossing. FIELD_STRUCT_DESC: 36-inch CM pipe through levee, 15.7 feet below crown. Flap gate on the waterward end. Concrete "U" headwall on both ends. BM stamped 9770-152 on top of the headwall on the waterward side. (USACE-1967). This entry matches the Drainage or Irrigation Structure referenced in O&M manual (HLM 3.43). FS Date: 4/18/2014

Flap gate and concrete headwall visible on waterward side.

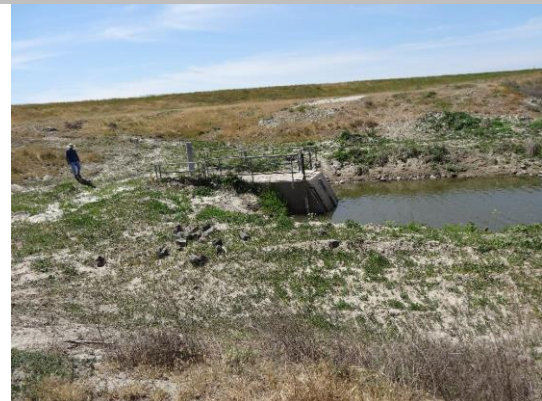
Photo 1 of 2 : UCIP_SP_2016_39482_71643.jpg

Comment Code						
Inspector Comment						
FS_ID:39482						
DS_ID:19824						
EP_NO: 6965						
Repair Type: Non-Urgent						
Crossing Status: Indicator Found						
UCIP Comments: Description of structure does not match. Need to contact owner. Current description includes concrete platform, trash screen, and gage reading on waterward side. Metal box located on waterward shoulder. Large plant facility locate on landward side.						
FIELD_STRUCT_DESC: 16-inch steel discharge pipe through levee, 7.4 feet below crown. CM cutoff wall around pipe in center of levee.						
Siphon breaker on apex of pipe on landward levee shoulder. Pump on waterward side, with timber platform on waterward berm for support.						
Pipe exposed on both slopes. (Permit No. 6965-1971)						
FS Date: 4/10/2014

View of structure located on waterward side.

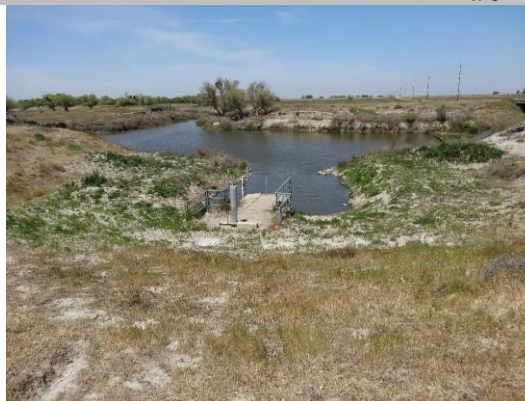
Photo 2 of 2 : UCIP_SP_2016_39482_71644.jpg

Comment Code					
Inspector Comment					
FS_ID:39482 DS_ID:19824 EP_NO: 6965 Repair Type: Non-Urgent Crossing Status: Indicator Found UCIP Comments: Description of structure does not match. Need to contact owner. Current description includes concrete platform, trash screen, and gage reading on waterward side. Metal box located on waterward shoulder. Large plant facility locate on landward side. FIELD_STRUCT_DESC: 16-inch steel discharge pipe through levee, 7.4 feet below crown. CM cutoff wall around pipe in center of levee. Siphon breaker on apex of pipe on landward levee shoulder. Pump on waterward side, with timber platform on waterward berm for support. Pipe exposed on both slopes. (Permit No. 6965-1971) FS Date: 4/10/2014

View of waterward side.

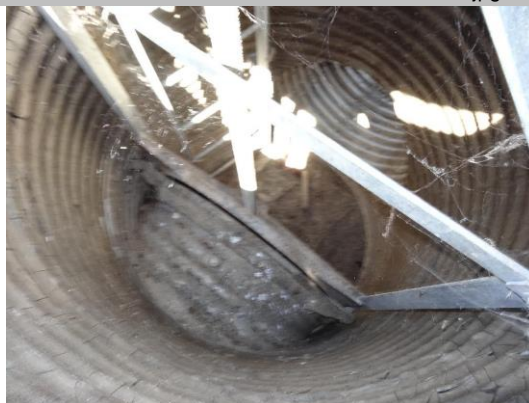
Photo 2 of 2 : UCIP_SP_2016_39465_66395.jpg

FS_ID:39465
DS_ID:19825
EP_NO: N/A
Repair Type: Non-Urgent
Crossing Status: Found
UCIP Comments: Sediment buildup inside pipe visible from landward side. Excess soil is also present on landward toe partially blocking concrete headwall and inlet. Recommend removing soil from landward toe and clear buildup inside.
FIELD_STRUCT_DESC: 36-inch CM pipe through the levee, 6.8 feet below crown. Slide gate in 48-inch CM pipe riser in the waterward slope. Concrete headwall on both ends. Pipe connects to 30-inch steel drainpipe on waterward side. Drainpipe extends to pump on waterward side, on support platform in channel. (USACE-1967). This entry matches the Drainage or Irrigation Structure referenced in O&M manual (HLM 3.54). Extension drainpipe and pump installed under Permit No. 12527 (1980).
FS Date: 4/18/2014

Inside view of cmp riser located on waterward slope.

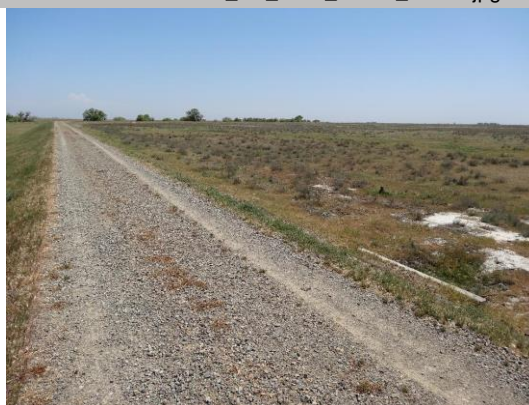
Photo 2 of 2 : UCIP_SP_2016_39466_66412.jpg

LM Start	3.69	Rating **	M	Issue No.	1247
LM End	3.69	Issue Type +	En	Location *	LS
Category	Supplemental			GPS Latitude/Longitude	
				Start	End
Item	DWR UCIP Field Study			37.251199 °	37.251199 °
				-120.774474 °	-120.774474 °
DWR ID					
Comment Code					
Inspector Comment					
FS_ID:39466 DS_ID:19826 EP_NO: N/A Repair Type: Non-Urgent Crossing Status: Found UCIP Comments: Sediment buildup inside crossing and is visible from landward side. Recommend clearing sediment buildup inside pipe and check wall integrity to determine condition. FIELD_STRUCT_DESC: 24-inch CM pipe through levee, 7.0 feet below crown. Flap gate on the waterward end. Concrete headwall on both ends. (USACE-1967). This entry matches the Drainage or Irrigation Structure referenced in O&M manual (HLM 3.77). FS Date: 4/18/2014

View of landward side.

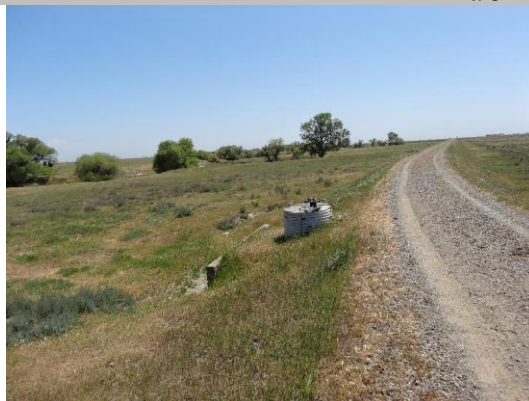
Photo 1 of 2 : UCIP_SP_2016_39467_66407.jpg

LM Start	3.89	Rating **	M	Issue No.	1248
LM End	3.89	Issue Type +	En	Location *	LS
Category	Supplemental			GPS Latitude/Longitude	
				Start	End
Item	DWR UCIP Field Study			37.250742 °	37.250742 °
				-120.771026 °	-120.771026 °
DWR ID					
Comment Code					
Inspector Comment					
FS_ID:39467					
DS_ID:19827					
EP_NO: N/A					
Repair Type: Non-Urgent					
Crossing Status: Found					
UCIP Comments: Sediment buildup inside crossing and is visible from landward side. Recommend clearing sediment buildup inside pipe and check wall integrity to determine condition.					
FIELD_STRUCT_DESC: 36-inch CM pipe through levee, 6.7 feet below crown. Slide gate in 48-inch CM pipe riser in the waterward slope. (USACE-1967). This entry matches the Drainage or Irrigation Structure referenced in O&M manual (HLM 3.97).					
FS Date: 4/18/2014

View of waterward side.

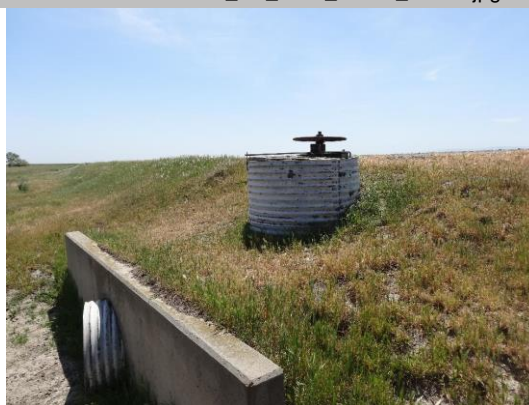
Photo 2 of 2 : UCIP_SP_2016_39467_66406.jpg

Slide gate inside CMP riser visible on waterward slope.

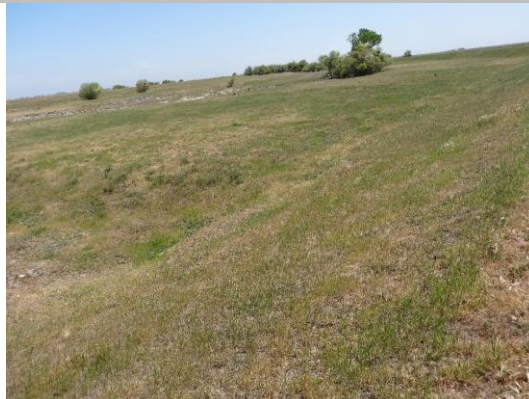
Photo 1 of 2 : UCIP_SP_2016_36606_66418.jpg

LM Start	4.09	Rating **	M	Issue No.	1235
LM End	4.09	Issue Type +	En	Location *	LS
Category	Supplemental			GPS Latitude/Longitude	
				Start	End
Item	DWR UCIP Field Study			37.248353 °	37.248353 °
				-120.768922 °	-120.768922 °
DWR ID					
Comment Code					
Inspector Comment					
FS_ID:36606					
DS_ID:19828					
EP_NO: N/A					
Repair Type: Non-Urgent					
Crossing Status: Found					
UCIP Comments: Dense vegetation limits the inspector's visibility to identify signs of pipe condition on landward toe--headwall blocked by dense vegetation. Recommend removing vegetation from landward toe.					
FIELD_STRUCT_DESC: 24-inch CM pipe through levee, 10.8 feet below crown. Flap gate on the waterward end. Concrete headwall on both ends. (USACE-1967). This entry matches the Drainage or Irrigation Structure referenced in O&M manual (HLM 4.17).					
FS Date: 4/18/2014

View of waterward side.

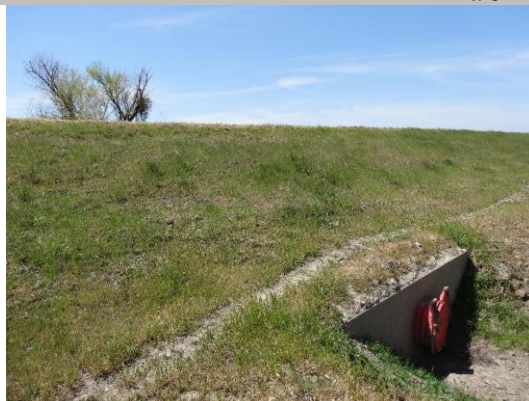
Photo 1 of 2 : UCIP_SP_2016_36607_66422.jpg

LM Start	4.33	Rating **	M	Issue No.	1236
LM End	4.33	Issue Type +	En	Location *	LS
Category	Supplemental			GPS Latitude/Longitude	
				Start	End
Item	DWR UCIP Field Study			37.246459 °	37.246459 °
				-120.765470 °	-120.765470 °
DWR ID					
Comment Code					
Inspector Comment					
FS_ID:36607 DS_ID:19829 EP_NO: N/A Repair Type: Non-Urgent Crossing Status: Found UCIP Comments: Dense vegetation limits the inspector's visibility to identify signs of pipe condition on landward toe--headwall blocked by dense vegetation. Recommend removing vegetation from landward toe. FIELD_STRUCT_DESC: 24-inch CM pipe through levee, 11.3 feet below crown. Flap gate on the waterward end. Concrete headwall on both ends. (USACE-1967). This entry matches the Drainage or Irrigation Structure referenced in O&M manual (HLM 4.41). FS Date: 4/18/2014

View of waterward side--concrete headwall and flap gate visible.

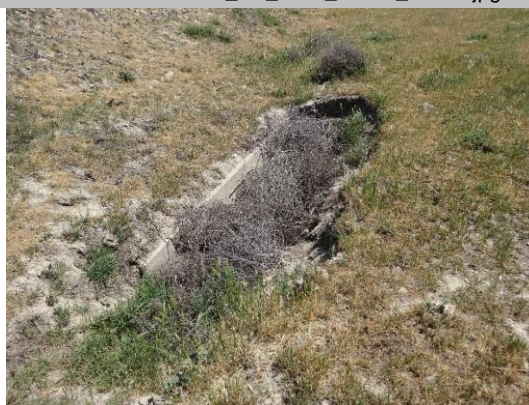
Photo 2 of 2 : UCIP_SP_2016_36607_66421.jpg

View of landward side--concrete headwall visible through dense vegetation.

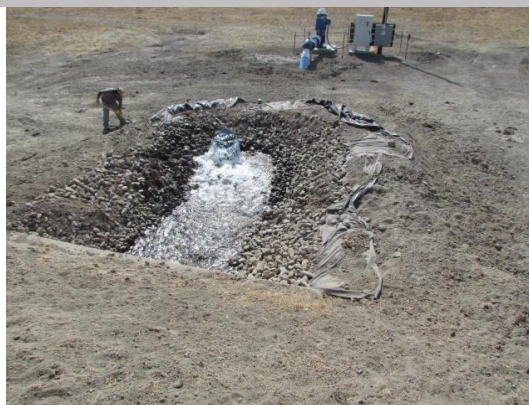
Photo 1 of 3 : SP_2016_NA0010_124_71_20160512_00027.jpg

LM Start	4.62	Rating **	U	Issue No.	71
LM End	4.62	Issue Type +	En	Location *	LS
Category	Earthen Levee			GPS Latitude/Longitude	
				Start	End
Item	Encroachments			37.243951 °	37.243951 °
				-120.761313 °	-120.761313 °
DWR ID	DWR_NA0010_06_f_2015_71				
Comment Code					
PI : Pipe					
Inspector Comment					
Landowner constructed dyke need drainage pipe.

Looking at dyke around drainage pipe at landward toe.

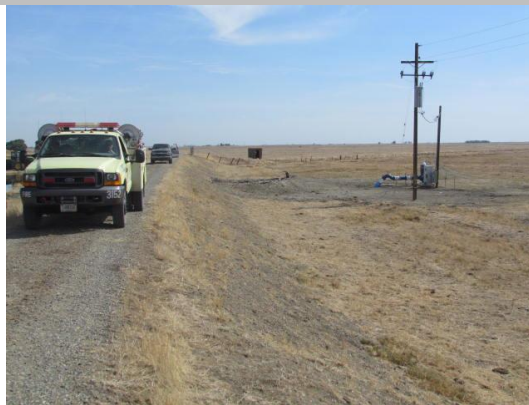
Photo 2 of 3 : SP_2016_NA0010_124_71_20160512_00028.jpg

Looking south at dyke around drainage pipe at landward toe.

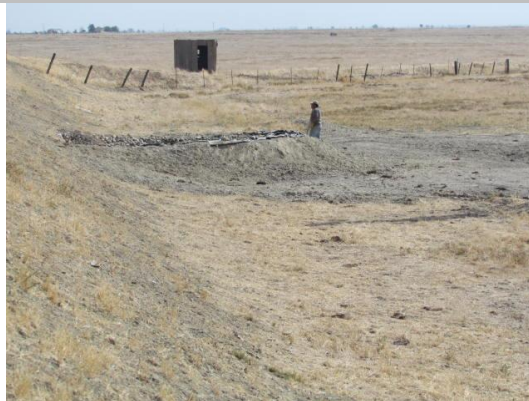
Photo 3 of 3 : SP_2016_NA0010_124_71_20160512_00029.jpg

LM Start	4.62	Rating **	U	Issue No.	71 (cont)	
LM End	4.62	Issue Type +	En	Location *	LS	
Category	Earthen Levee			GPS Latitude/Longitude		
				Start		End
Item	Encroachments			37.243951 °		37.243951 °
				-120.761313 °		-120.761313 °
DWR ID	DWR_NA0010_06_f_2015_71					
Comment Code						
PI : Pipe						
Inspector Comment						
Landowner constructed dyke need drainage pipe.

Looking south at dyke around drainage pipe at landward toe.

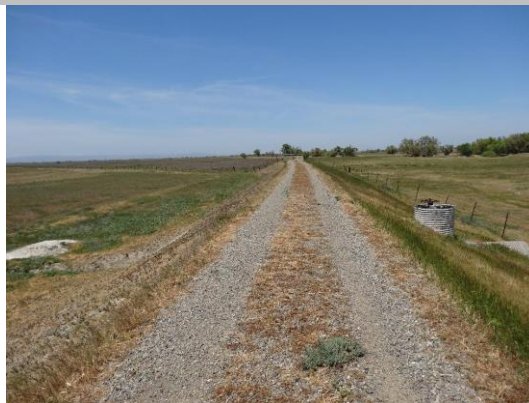
Photo 1 of 2 : UCIP_SP_2016_39468_66425.jpg

LM Start	4.62	Rating **	M	Issue No.	1249
LM End	4.62	Issue Type +	En	Location *	LS
Category	Supplemental			GPS Latitude/Longitude	
				Start	End
Item	DWR UCIP Field Study			37.243946 °	37.243946 °
				-120.761296 °	-120.761296 °
DWR ID					
Comment Code					
Inspector Comment					
FS_ID:39468 DS_ID:19830 EP_NO: N/A Repair Type: Non-Urgent Crossing Status: Found UCIP Comments: Sediment buildup inside crossing visible from landward side. Recommend clearing sediment buildup inside pipe and check wall integrity to determine condition. FIELD_STRUCT_DESC: 36-inch CM pipe through levee, 6.9 feet below crown. Slide gate in 48-inch CM pipe riser in the waterward slope. Concrete headwall on the landward end. Concrete saddle and apron on the waterward end. (USACE-1967). This entry matches the Drainage or Irrigation Structure referenced in O&M manual (HLM 4.70). FS Date: 4/18/2014

Overview of levee crown at crossing.

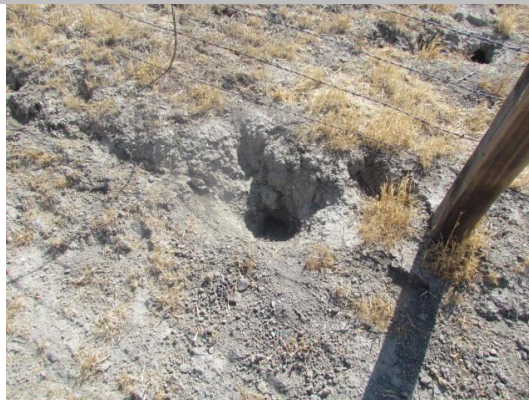
Photo 1 of 2 : SP_2016_NA0010_124_10_20160512_00012.jpg

LM Start	4.66	Rating **	M	Issue No.	10
LM End	4.66	Issue Type +	Ma	Location *	LS
Category	Earthen Levee			GPS Latitude/Longitude	
				Start	End
Item	Animal Control			37.243540 °	37.243540 °
				-120.760782 °	-120.760782 °
DWR ID	DWR_NA0010_06_s_2012_10				
Comment Code					
A3 : No rodents visible, but rodent burrows visible; need to backfill and compact or grout burrows.					
Inspector Comment					
Rodent holes next to fence post on landward slope.

Looking at rodent hole along fence line on landward slope.

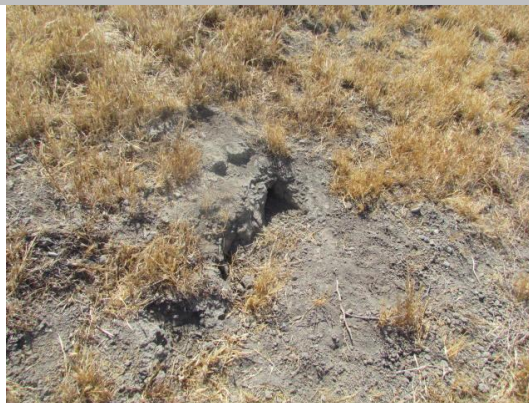
Photo 2 of 2 : SP_2016_NA0010_124_10_20160512_00013.jpg

LM Start	4.66	Rating **	M	Issue No.	10 (cont)	
LM End	4.66	Issue Type +	Ma	Location *	LS	
Category	Earthen Levee			GPS Latitude/Longitude		
				Start		End
Item	Animal Control			37.243540 °		37.243540 °
				-120.760782 °		-120.760782 °
DWR ID	DWR_NA0010_06_s _ 2012_10					
Comment Code						
A3 : No rodents visible, but rodent burrows visible; need to backfill and compact or grout burrows.						
Inspector Comment						
Rodent holes next to fence post on landward slope.

Looking at typical rodent holes on landward slope.

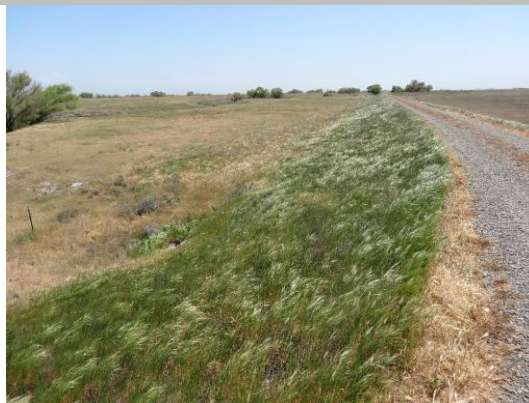
Photo 1 of 2 : UCIP_SP_2016_36609_66433.jpg

LM Start	4.67	Rating **	M	Issue No.	1237
LM End	4.67	Issue Type +	En	Location *	LS
Category	Supplemental			GPS Latitude/Longitude	
				Start	End
Item	DWR UCIP Field Study			37.243408 °	37.243408 °
				-120.760564 °	-120.760564 °
DWR ID					
Comment Code					
Inspector Comment					
FS_ID:36609 DS_ID:19831 EP_NO: N/A Repair Type: Non-Urgent Crossing Status: Found UCIP Comments: Need to contact owner. Recommend removing tall grass on landward toe to determine condition of crossing from landward side. FIELD_STRUCT_DESC: 24-inch CM pipe through levee, 11.8 feet below crown. Flap gate on the waterward end. Concrete headwall on both ends. (USACE-1967). This entry matches the Drainage or Irrigation Structure referenced in O&M manual (HLM 4.75). FS Date: 4/18/2014

View of waterward side.

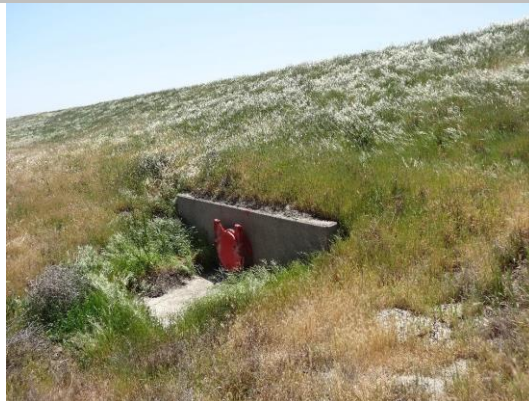
Photo 2 of 2 : UCIP_SP_2016_36609_66432.jpg

LM Start	4.67	Rating **	M	Issue No.	1237 (cont)
LM End	4.67	Issue Type +	En	Location *	LS
Category	Supplemental			GPS Latitude/Longitude	
				Start	End
Item	DWR UCIP Field Study			37.243408 °	37.243408 °
				-120.760564 °	-120.760564 °
DWR ID					
Comment Code					
Inspector Comment					
FS_ID:36609 DS_ID:19831 EP_NO: N/A Repair Type: Non-Urgent Crossing Status: Found UCIP Comments: Need to contact owner. Recommend removing tall grass on landward toe to determine condition of crossing from landward side. FIELD_STRUCT_DESC: 24-inch CM pipe through levee, 11.8 feet below crown. Flap gate on the waterward end. Concrete headwall on both ends. (USACE-1967). This entry matches the Drainage or Irrigation Structure referenced in O&M manual (HLM 4.75). FS Date: 4/18/2014

Flap gate, concrete headwall and apron visible on waterward toe.

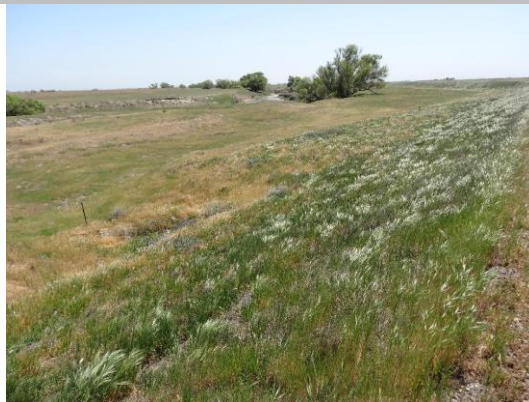
Photo 1 of 2 : UCIP_SP_2016_36610_66436.jpg

Comment Code					
Inspector Comment					
FS_ID:36610 DS_ID:19862 EP_NO: N/A Repair Type: Non-Urgent Crossing Status: Found UCIP Comments: Dense vegetation limits the inspector's visibility to identify signs of pipe failure (leaks) along the waterward slope. Recommend removing vegetation along waterward slope to conduct proper inspection of structure. Also recommend removing dense vegetation blocking landward headwall. FIELD_STRUCT_DESC: 24-inch CM pipe through levee, 10.8 feet below crown. Flap gate on the waterward end. Concrete headwall on both ends. (USACE-1967). This entry matches the Drainage or Irrigation Structure referenced in O&M manual (HLM 4.94). FS Date: 4/18/2014

View of waterward side.

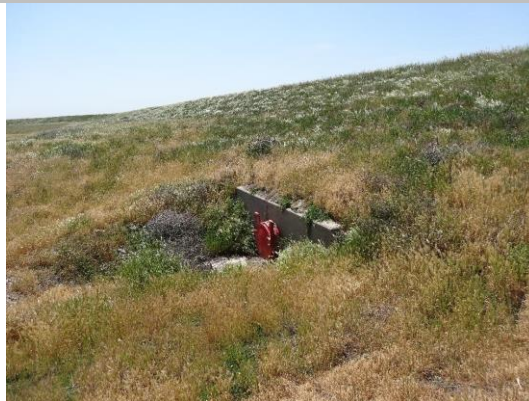
Photo 2 of 2 : UCIP_SP_2016_36610_66438.jpg

Item	DWR UCIP Field Study			37.242024 °		37.242024 °
				-120.757602 °		-120.757602 °
DWR ID						
Comment Code						
Inspector Comment						
FS_ID:36610 DS_ID:19862 EP_NO: N/A Repair Type: Non-Urgent Crossing Status: Found UCIP Comments: Dense vegetation limits the inspector's visibility to identify signs of pipe failure (leaks) along the waterward slope. Recommend removing vegetation along waterward slope to conduct proper inspection of structure. Also recommend removing dense vegetation blocking landward headwall. FIELD_STRUCT_DESC: 24-inch CM pipe through levee, 10.8 feet below crown. Flap gate on the waterward end. Concrete headwall on both ends. (USACE-1967). This entry matches the Drainage or Irrigation Structure referenced in O&M manual (HLM 4.94). FS Date: 4/18/2014

View of flap gate, concrete headwall and apron located on waterward side.

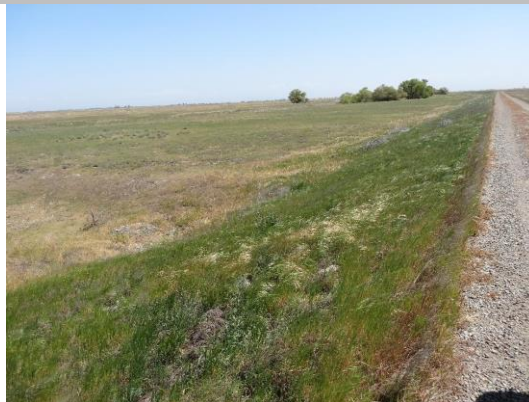
Photo 1 of 2 : UCIP_SP_2016_39875_61599.jpg

LM Start	5.26	Rating **	M	Issue No.	1250
LM End	5.26	Issue Type +	En	Location *	LS
Category	Supplemental			GPS Latitude/Longitude	
				Start	End
Item	DWR UCIP Field Study			37.239098 °	37.239098 °
				-120.751774 °	-120.751774 °
DWR ID					
Comment Code					
Inspector Comment					
FS_ID:39875 DS_ID:19863 EP_NO: N/A Repair Type: Non-Urgent Crossing Status: Found UCIP Comments: Clear vegetation from waterward slope and landward headwall. FIELD_STRUCT_DESC: 24-inch CM pipe through levee, 10.9 feet below crown. Flap gate on the waterward end. Concrete headwall on both ends. (USACE-1967). This entry matches the Drainage or Irrigation Structure referenced in O&M manual (HLM 5.34). FS Date: 4/18/2014

View of waterward side.

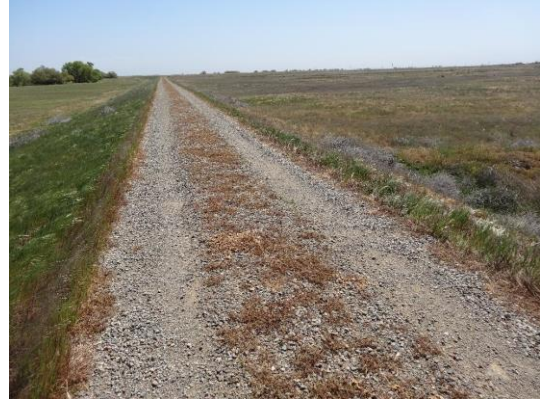
Photo 2 of 2 : UCIP_SP_2016_39875_61598.jpg

LM Start	5.26	Rating **	M	Issue No.	1250 (cont)	
LM End	5.26	Issue Type +	En	Location *	LS	
Category	Supplemental			GPS Latitude/Longitude		
				Start		End
Item	DWR UCIP Field Study			37.239098 °		37.239098 °
				-120.751774 °		-120.751774 °
DWR ID						
Comment Code						
Inspector Comment						
FS_ID:39875						
DS_ID:19863						
EP_NO: N/A						
Repair Type: Non-Urgent						
Crossing Status: Found						
UCIP Comments: Clear vegetation from waterward slope and landward headwall.						
FIELD_STRUCT_DESC: 24-inch CM pipe through levee, 10.9 feet below crown. Flap gate on the waterward end. Concrete headwall on both ends. (USACE-1967). This entry matches the Drainage or Irrigation Structure referenced in O&M manual (HLM 5.34).						
FS Date: 4/18/2014

Overview of levee crown at crossing.

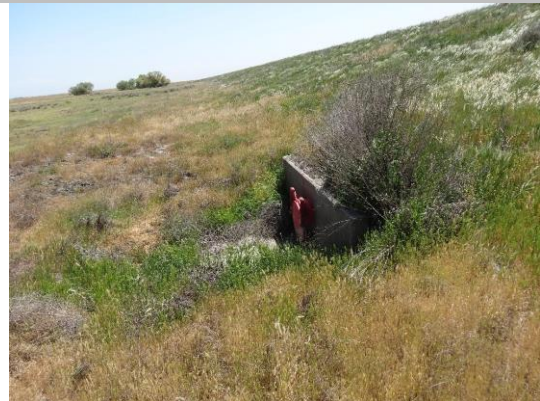
Photo 1 of 2 : UCIP_SP_2016_36611_66441.jpg

Comment Code					
Inspector Comment					
FS_ID:36611 DS_ID:19864 EP_NO: N/A Repair Type: Non-Urgent Crossing Status: Found UCIP Comments: Dense vegetation limits the inspector's visibility to identify signs of pipe failure (leaks) along the waterward slope. Recommend removing vegetation along pipe alignment to conduct proper inspection of structure. Also recommend removing excess vegetation at landward headwall. FIELD_STRUCT_DESC: 24-inch CM pipe through levee, 11.0 feet below crown. Flap gate on the waterward end. Concrete headwall on both ends. (USACE-1967). This entry matches the Drainage or Irrigation Structure referenced in O&M manual (HLM 5.63). FS Date: 4/18/2014

Concrete headwall and flap gate visible on waterward toe.
