**Flood Control Project Maintenance
Levee Inspections****LMA District Cover Sheet****Spring 2016 Levee Inspection Results****Lower San Joaquin Levee District**

Spring 2016 Levee Inspection Results

Lower San Joaquin Levee District

Waterway			Bank	Unit Miles
Unit No. 01 San Joaquin River			Right	22.52
	Spring (March - May)	Summer (June - August)	(September - November) Fall	Winter (December - February)
Unit Maintenance Rating (Fall Only)				
Date of Inspection	5/16/2016 - 5/19/2016			
DWR Inspector	Richard Willoughby			
Accompanied By

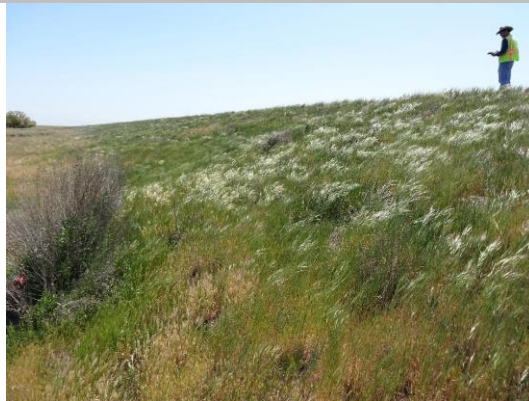
Photo 2 of 2 : UCIP_SP_2016_36611_66440.jpg

Item	DWR UCIP Field Study			37.238610 °	37.238610 °	
				-120.746591 °	-120.746591 °	
DWR ID						
Comment Code						
Inspector Comment						
FS_ID:36611 DS_ID:19864 EP_NO: N/A Repair Type: Non-Urgent Crossing Status: Found UCIP Comments: Dense vegetation limits the inspector's visibility to identify signs of pipe failure (leaks) along the waterward slope. Recommend removing vegetation along pipe alignment to conduct proper inspection of structure. Also recommend removing excess vegetation at landward headwall. FIELD_STRUCT_DESC: 24-inch CM pipe through levee, 11.0 feet below crown. Flap gate on the waterward end. Concrete headwall on both ends. (USACE-1967). This entry matches the Drainage or Irrigation Structure referenced in O&M manual (HLM 5.63). FS Date: 4/18/2014

View of waterward side--dense vegetation covers slope.

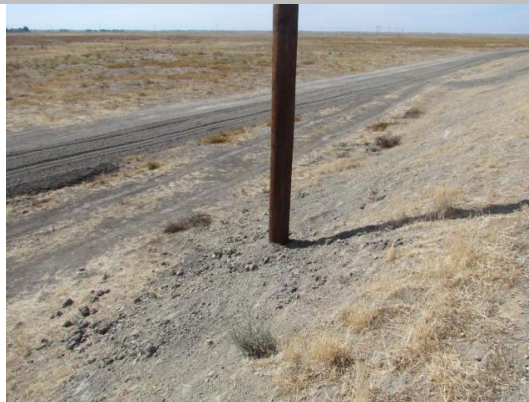
Photo 1 of 2 : SP_2016_NA0010_124_69_20160512_00021.jpg

LM Start	5.93	Rating **	U	Issue No.	69
LM End	6.25	Issue Type +	En	Location *	LS
Category	Earthen Levee			GPS Latitude/Longitude	
				Start	End
Item	Encroachments			37.236936 °	37.235487 °
				-120.740384 °	-120.737685 °
DWR ID	DWR_NA0010_06_f_2015_69				
Comment Code					
PO : Pole					
Inspector Comment					
Several PG& E poles within this section at the landward toe and slope.

Looking at power pole on landward slope.

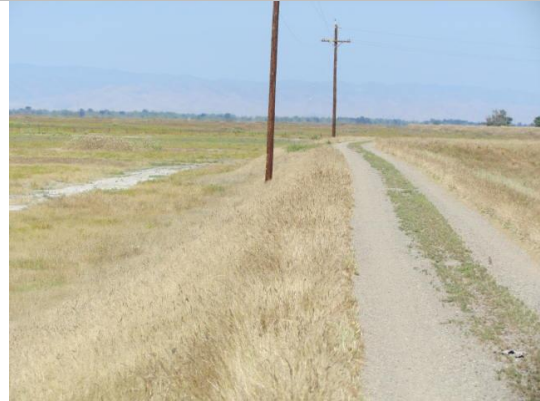
Photo 2 of 2 : SP_2016_NA0010_124_69_20160523_00168.jpg

LM Start	5.93	Rating **	U	Issue No.	69 (cont)	
LM End	6.25	Issue Type +	En	Location *	LS	
Category	Earthen Levee			GPS Latitude/Longitude		
				Start		End
Item	Encroachments			37.236936 °		37.235487 °
				-120.740384 °		-120.737685 °
DWR ID	DWR_NA0010_06_f _ 2015_69					
Comment Code						
PO : Pole						
Inspector Comment						
Several PG& E poles within this section at the landward toe and slope.

Looking west at several PG&E poles on landward slope.

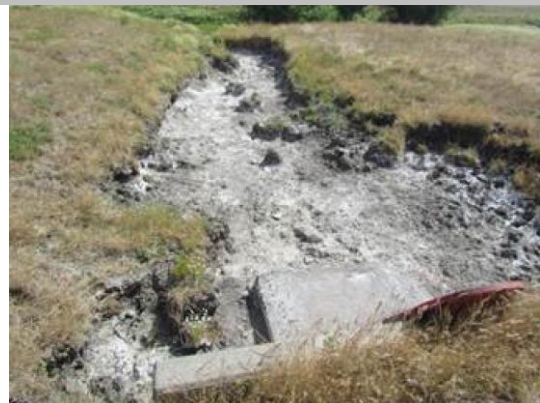
Photo 1 of 2 : UCIP_SP_2016_48510_75117.jpg

Comment Code					
Inspector Comment					
FS_ID:48510 DS_ID:19865 EP_NO: N/A Repair Type: Urgent Crossing Status: Found UCIP Comments: 5/26/2016 Erosion is undermining the WS headwall of drainage structure (photos of WS headwall provided by DWR Inspector R. Willoughby). Potential pipe failure at the outlet just behind headwall, recommend completing internal wall integrity of pipe length through levee to determine extent of damage to pipe. 4/18/2014 Need to contact owner. Sediment buildup in pipe visible on landside-- recommend clearing. FIELD_STRUCT_DESC: 24-inch corrugated metal drainage pipe through levee, 9.0 feet below crown. Concrete headwall on both waterside (WS) and landside (LS) ends. Flap gate on the WS end. (USACE-1967). This entry matches the Drainage or Irrigation Structure referenced in O&M manual (HLM 6.06). [Additional Reference(s): DWR Levee Log, 1990. USACE San Joaquin River O&M Manual 601, 1967 Part 1 (HLM 6.06)]. FS Date: 5/26/2016 10:46:00 AM

Overview of outlet looking towards channel.

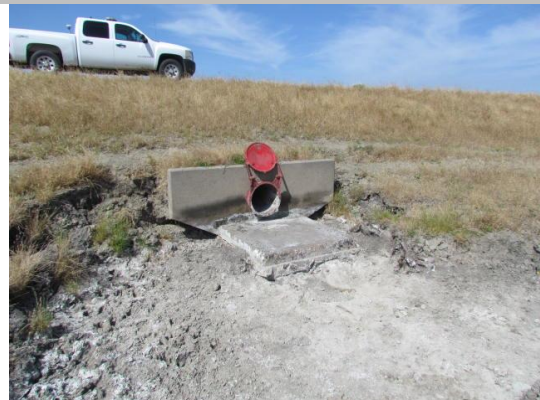
Photo 1 of 6 : SP_2016_NA0010_124_1_20160523_00170.jpg

LM Start	5.98	Rating **	U	Issue No.	1
LM End	5.98	Issue Type +	Ma	Location *	WS
Category	Interior Drainage & Piping Systems			GPS Latitude/Longitude	
				Start	End
Item	Erosion Areas			37.236386 °	37.236386 °
				-120.739706 °	-120.739706 °
DWR ID	DWR_NA0010_06_s_2016_1				
Comment Code					
Inspector Comment					
Erosion is undermining the headwall on both sides of the drainage structure.

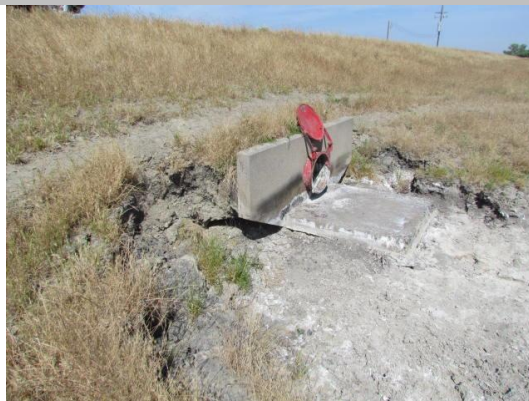
Photo 5 of 6 : SP_2016_NA0010_124_1_20160523_00169.jpg

Looking west at erosion on waterside around structure.

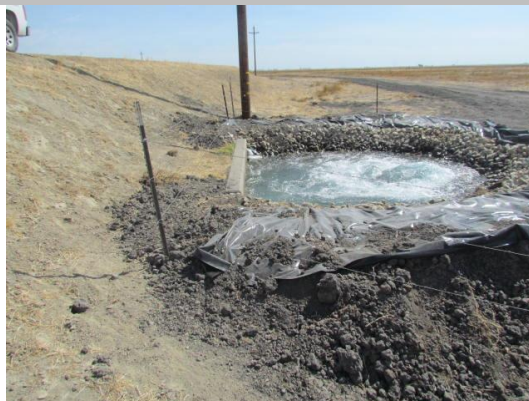
Photo 1 of 5 : SP_2016_NA0010_124_70_20160512_00022.jpg

LM Start	5.98	Rating **	U	Issue No.	70
LM End	5.98	Issue Type +	En	Location *	LS
Category	Earthen Levee			GPS Latitude/Longitude	
				Start	End
Item	Encroachments			37.236382 °	37.236382 °
				-120.739709 °	-120.739709 °
DWR ID	DWR_NA0010_06_f_2015_70				
Comment Code					
PI : Pipe					
Inspector Comment					
Pipe from well at 15ft line with dyke around pipe to close to landward toe.

Looking south at dyke connected to drainage structure at landward toe.

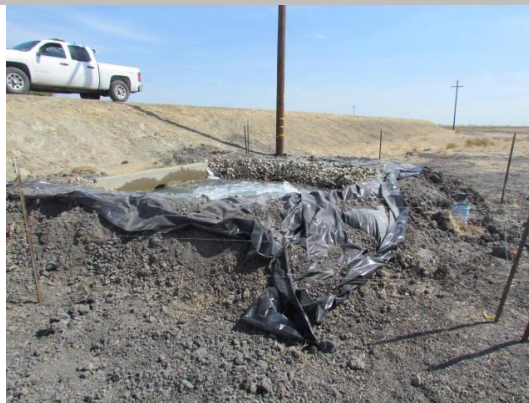
Photo 2 of 5 : SP_2016_NA0010_124_70_20160512_00023.jpg

Looking southwest at dyke connected to drainage structure at landward toe.

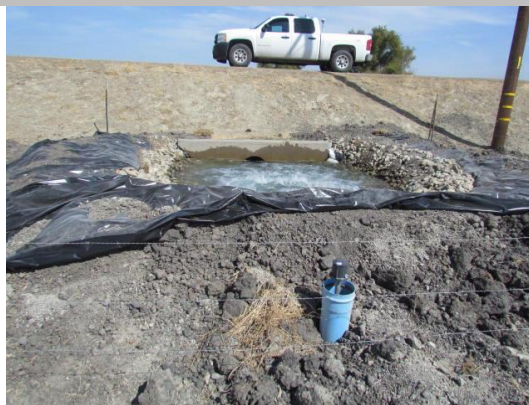
Photo 3 of 5 : SP_2016_NA0010_124_70_20160512_00024.jpg

Looking west at dyke connected to drainage structure at landward toe.

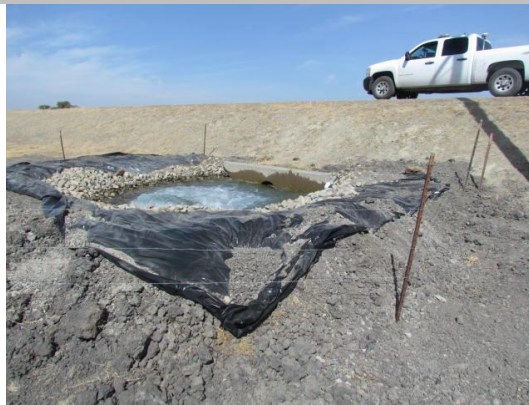
Photo 4 of 5 : SP_2016_NA0010_124_70_20160512_00025.jpg

Looking northwest at dyke connected to drainage structure at landward toe.

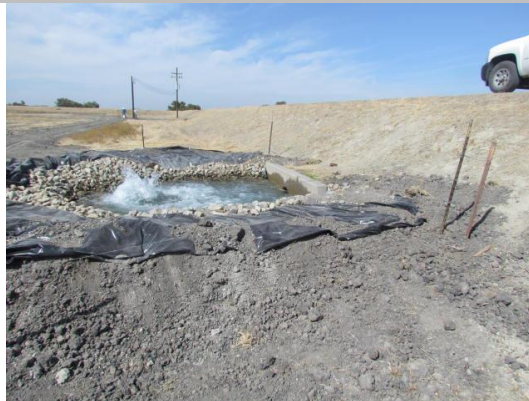
Photo 5 of 5 : SP_2016_NA0010_124_70_20160512_00026.jpg

LM Start	5.98	Rating **	U	Issue No.	70 (cont)	
LM End	5.98	Issue Type +	En	Location *	LS	
Category	Earthen Levee			GPS Latitude/Longitude		
				Start		End
Item	Encroachments			37.236382 °		37.236382 °
				-120.739709 °		-120.739709 °
DWR ID	DWR_NA0010_06_f_2015_70					
Comment Code						
PI : Pipe						
Inspector Comment						
Pipe from well at 15ft line with dyke around pipe to close to landward toe.

Looking north at dyke connected to drainage structure at landward toe.

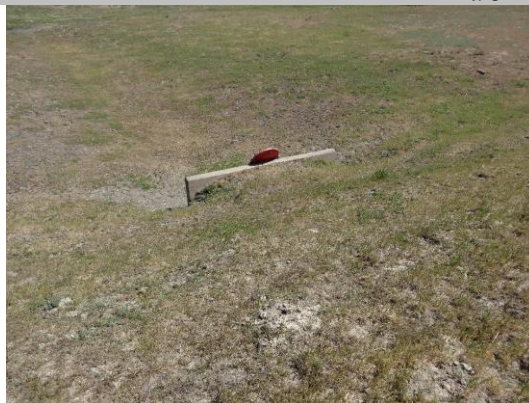
Photo 1 of 2 : UCIP_SP_2016_39471_61650.jpg

LM Start	7.21	Rating **	M	Issue No.	1219
LM End	7.21	Issue Type +	En	Location *	LS
Category	Supplemental			GPS Latitude/Longitude	
				Start	End
Item	DWR UCIP Field Study			37.226102 °	37.226102 °
				-120.722739 °	-120.722739 °
DWR ID					
Comment Code					
Inspector Comment					
FS_ID:39471 DS_ID:19868 EP_NO: N/A Repair Type: Non-Urgent Crossing Status: Found UCIP Comments: Need to contact owner. Clear animal from waterward side. Some sediment buildup in pipe visible landward side--recommend clearing. FIELD_STRUCT_DESC: 24-inch CM pipe through levee, 10.6 feet below crown. Flap gate on the waterward end. Concrete headwall on both ends. (USACE-1967). This entry matches the Drainage or Irrigation Structure referenced in O&M manual (HLM 7.29). FS Date: 4/18/2014

View of waterward side.

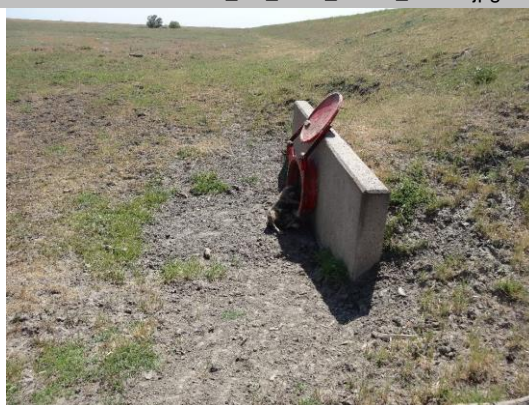
Photo 2 of 2 : UCIP_SP_2016_39471_61649.jpg

Concrete headwall and flap gate visible on waterward side. Dead animal inside pipe.

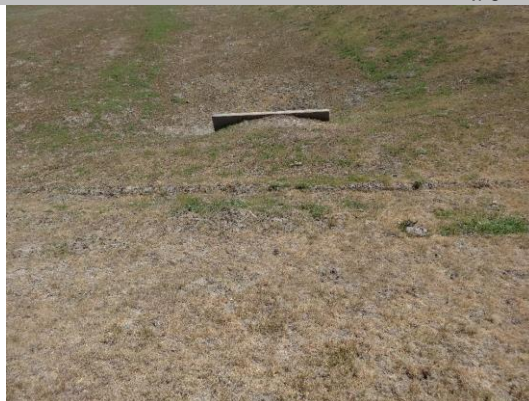
Photo 1 of 2 : UCIP_SP_2016_39472_66462.jpg

LM Start	7.66	Rating **	M	Issue No.	1220
LM End	7.66	Issue Type +	En	Location *	LS
Category	Supplemental			GPS Latitude/Longitude	
				Start	End
Item	DWR UCIP Field Study			37.222743 °	37.222743 °
				-120.716416 °	-120.716416 °
DWR ID					
Comment Code					
Inspector Comment					
FS_ID:39472 DS_ID:19869 EP_NO: N/A Repair Type: Non-Urgent Crossing Status: Found UCIP Comments: Some sediment buildup in pipe visible on landward side--recommend clearing. FIELD_STRUCT_DESC: 24-inch CM pipe through levee, 11.8 feet below crown. Flap gate on the waterward end. Concrete headwall on both ends. (USACE-1967). This entry matches the Drainage or Irrigation Structure referenced in O&M manual (HLM 7.74). Skewed crossing FS Date: 4/18/2014

View of waterward side.

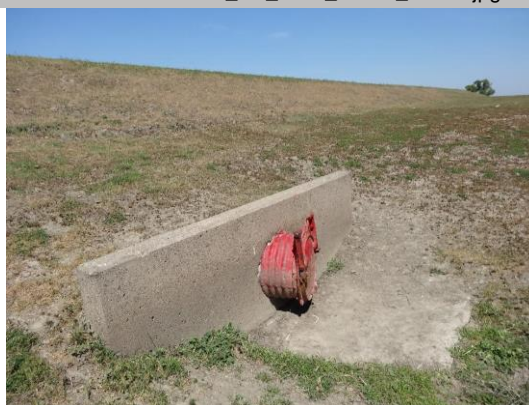
Photo 2 of 2 : UCIP_SP_2016_39472_66461.jpg

Pipe crosses levee at an angle.

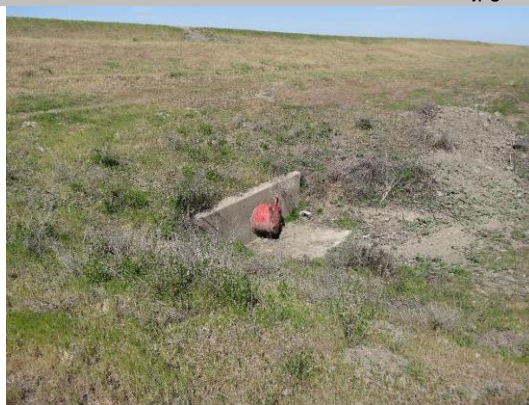
Photo 2 of 2 : UCIP_SP_2016_39473_61673.jpg

LM Start	8.13	Rating **	M	Issue No.	1221
LM End	8.13	Issue Type +	En	Location *	LS
Category	Supplemental			GPS Latitude/Longitude	
				Start	End
Item	DWR UCIP Field Study			37.216547 °	37.216547 °
				-120.713000 °	-120.713000 °
DWR ID					
Comment Code					
Inspector Comment					
FS_ID:39473 DS_ID:19870 EP_NO: N/A Repair Type: Non-Urgent Crossing Status: Found UCIP Comments: Sediment buildup in pipe--recommend contacting owner to clear sediment. FIELD_STRUCT_DESC: 24-inch CM pipe through levee, 16.5 feet below crown. Flap gate on the waterward end. Concrete headwall on both ends. (USACE-1967). This entry matches the Drainage or Irrigation Structure referenced in O&M manual (HLM 8.21). FS Date: 4/18/2014

Pipe crosses levee at an angle.

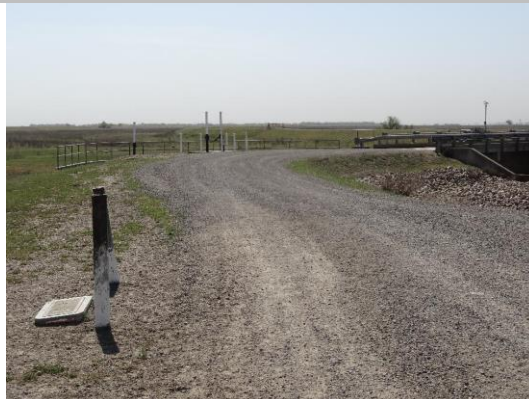
Photo 1 of 2 : UCIP_SP_2016_42525_72925.jpg

LM Start	9.52	Rating **	M	Issue No.	1256	
LM End	9.52	Issue Type +	En	Location *	LS	
Category	Supplemental			GPS Latitude/Longitude		
				Start		End
Item	DWR UCIP Field Study			37.202481 °		37.202481 °
				-120.695303 °		-120.695303 °
DWR ID						
Comment Code						
Inspector Comment						
FS_ID:42525 DS_ID:19872 EP_NO: N/A Repair Type: Non-Urgent Crossing Status: Indicator Found UCIP Comments: 12/5/14 Accidently missed updating record. Photos have been added and coordinates have been updated. Unable to confirm if crossing is the same cable line originally identified in desk study at levee mile 6.43. Recommend contacting owner to confirm alignment, size of conduit, and permit issued. FIELD_STRUCT_DESC: Buried telephone cable under crown of roadway. FS Date: 4/18/2014

Service box located on waterward levee shoulder.

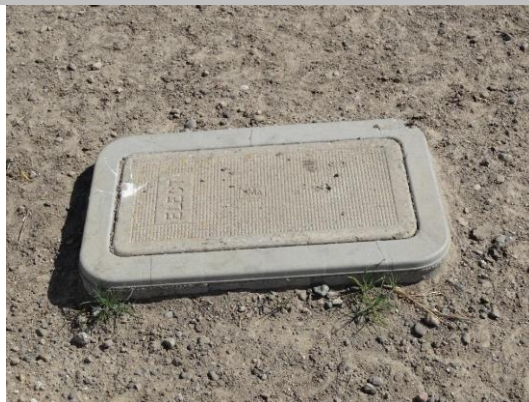
Photo 2 of 2 : UCIP_SP_2016_42525_72924.jpg

Service box is for electrical conduit.

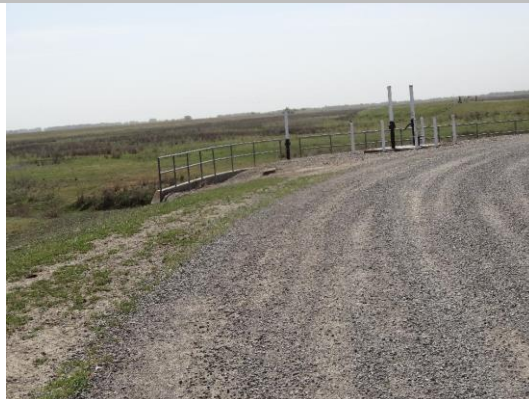
Photo 1 of 2 : UCIP_SP_2016_42524_72922.jpg

LM Start	9.56	Rating **	M	Issue No.	1255
LM End	9.56	Issue Type +	En	Location *	LS
Category	Supplemental			GPS Latitude/Longitude	
				Start	End
Item	DWR UCIP Field Study			37.202014 °	37.202014 °
				-120.694820 °	-120.694820 °
DWR ID					
Comment Code					
Inspector Comment					
FS_ID:42524 DS_ID:19873 EP_NO: N/A Repair Type: Non-Urgent Crossing Status: Found UCIP Comments: 12/5/14 Accidently missed entry. Photos have been added and coordinates have been updated by Olivia Magana. Unable to determine condition of crossing due to limited access. Recommend contacting owner to provide condition of crossing. FIELD_STRUCT_DESC: 36-inch CM pipe through levee, 14.0 feet below crown. Slide gate in concrete diversion box on the waterward shoulder. FS Date: 4/18/2014

Overview of levee crown looking upstream.

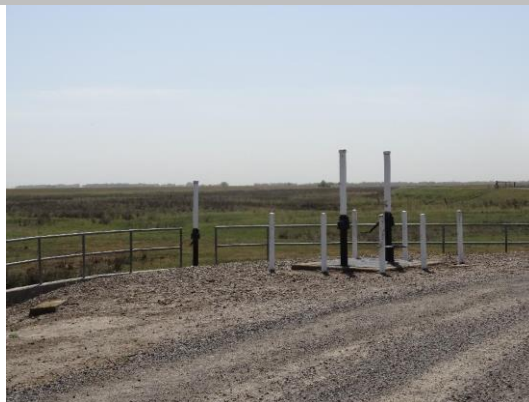
Photo 2 of 2 : UCIP_SP_2016_42524_72921.jpg

Concrete box located on waterward side.

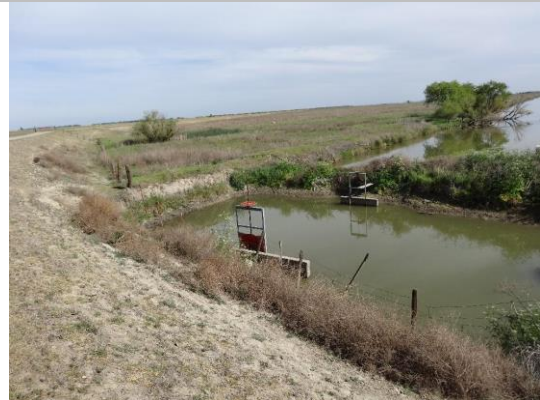
Photo 1 of 2 : UCIP_SP_2016_39475_61691.jpg

LM Start	9.66	Rating **	M	Issue No.	1223
LM End	9.66	Issue Type +	En	Location *	LS
Category	Supplemental			GPS Latitude/Longitude	
				Start	End
Item	DWR UCIP Field Study			37.200948 °	37.200948 °
				-120.694362 °	-120.694362 °
DWR ID					
Comment Code					
Inspector Comment					
FS_ID:39475					
DS_ID:19874					
EP_NO: N/A					
Repair Type: Non-Urgent					
Crossing Status: Found					
UCIP Comments: Waterward side not visible--need to determine alignment.					
FIELD_STRUCT_DESC: 36-inch CM pipe through levee, 14.0 feet below crown. Slide gate in concrete diversion box on the waterward shoulder.					
FS Date: 4/17/2014

View of landward side.

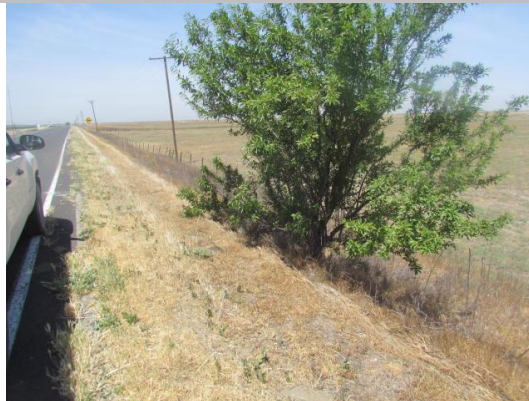
Photo 1 of 1 : SP_2016_NA0010_124_14_20160512_00014.jpg

LM Start	11.49	Rating **	M	Issue No.	14
LM End	11.49	Issue Type +	Ma	Location *	WS
Category	Earthen Levee			GPS Latitude/Longitude	
				Start	End
Item	Trim / Thin Trees			37.186189 °	37.186189 °
				-120.668476 °	-120.668476 °
DWR ID	DWR_NA0010_06_s_2015_14				
Comment Code					
T1 : Trim trees to at least five feet above ground level.					
Inspector Comment					
Almond tree located along Sandy Mush Rd. on waterward slope.

Looking west at tree on waterward slope.

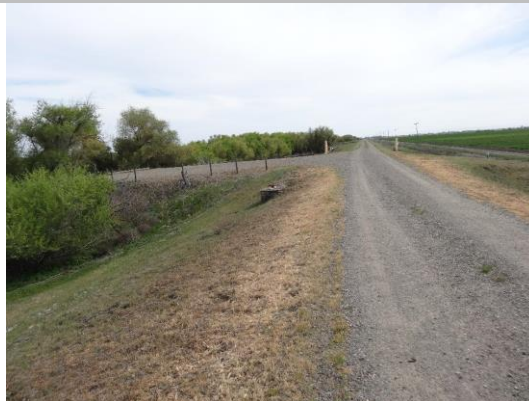
Photo 1 of 2 : UCIP_SP_2016_39476_66488.jpg

FS_ID:39476
DS_ID:19876
EP_NO: N/A
Repair Type: Non-Urgent
Crossing Status: Found
UCIP Comments: Clear debris from waterward and landward toes.
FIELD_STRUCT_DESC: 36-inch CM pipe through levee, 17.0 feet below crown. Slide gate in pipe riser on the waterward slope. (USACE-1967). This entry matches the Drainage or Irrigation Structure referenced in O&M manual (HLM 11.82).
FS Date: 4/17/2014

View of waterward side.

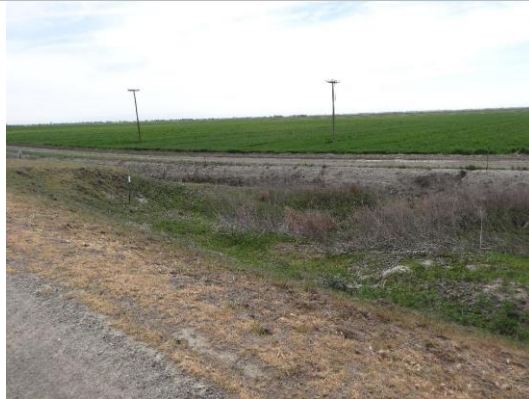
Photo 2 of 2 : UCIP_SP_2016_39476_66487.jpg

View of landward side.

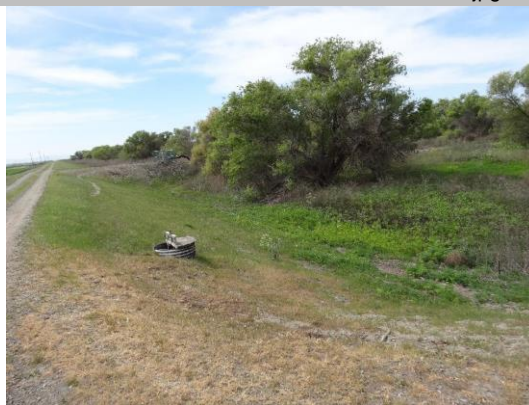
Photo 2 of 2 : UCIP_SP_2016_39477_66494.jpg

View of waterward slope.

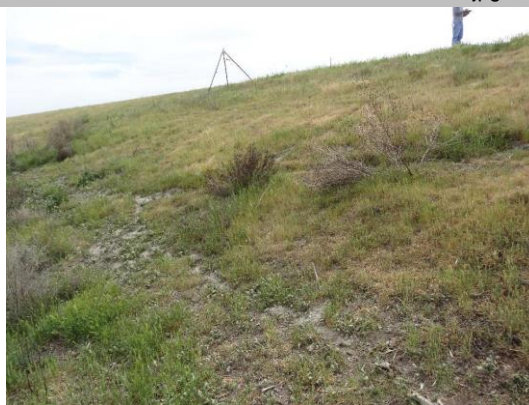
Photo 1 of 2 : UCIP_SP_2016_39478_66496.jpg

LM Start	14.36	Rating **	M	Issue No.	1226
LM End	14.36	Issue Type +	En	Location *	LS
Category	Supplemental			GPS Latitude/Longitude	
				Start	End
Item	DWR UCIP Field Study			37.167888 °	37.167888 °
				-120.636419 °	-120.636419 °
DWR ID					
Comment Code					
Inspector Comment					
FS_ID:39478 DS_ID:19878 EP_NO: N/A Repair Type: Non-Urgent Crossing Status: Found UCIP Comments: Not accessible--crossing is buried on landward side. Need to contact owner to determine status. FIELD_STRUCT_DESC: 24-inch CM pipe through levee, 12.3 feet below crown. Flap gate on the waterward end. (USACE-1967). This entry matches the Drainage or Irrigation Structure referenced in O&M manual (HLM 14.44). FS Date: 4/17/2014

View of waterward slope.

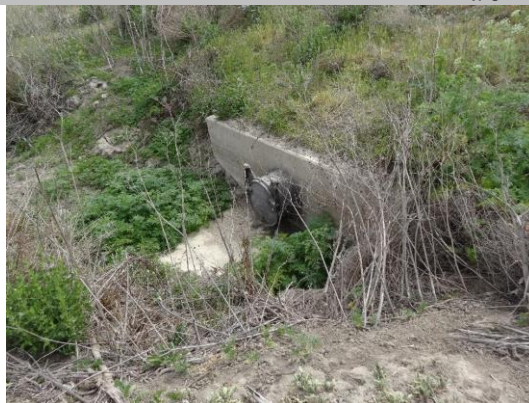
Photo 2 of 2 : UCIP_SP_2016_39478_66497.jpg

View of pipe daylight, flap gate, and concrete headwall visible on waterward toe.

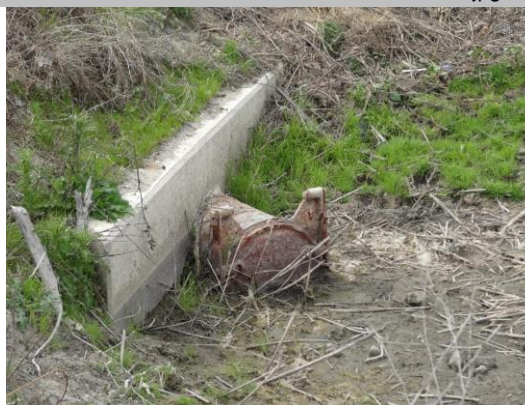
Photo 1 of 2 : UCIP_SP_2016_39480_66507.jpg

LM Start	15.68	Rating **	M	Issue No.	1227
LM End	15.68	Issue Type +	En	Location *	LS
Category	Supplemental			GPS Latitude/Longitude	
				Start	End
Item	DWR UCIP Field Study			37.156934 °	37.156934 °
				-120.617210 °	-120.617210 °
DWR ID					
Comment Code					
Inspector Comment					
FS_ID:39480 DS_ID:19884 EP_NO: N/A Repair Type: Non-Urgent Crossing Status: Found UCIP Comments: Need to contact owner. Sediment buildup on both the waterward and landward side. Recommend removing sediment buildup from both side. Also recommend clearing excess sediment inside crossing. FIELD_STRUCT_DESC: 24-inch CM pipe through levee, 14.0 feet below crown. Flap gate on the waterward end. (USACE-1967). This entry matches the Drainage or Irrigation Structure referenced in O&M manual (HLM 15.76). FS Date: 4/17/2014

Flap gate buried halfway on waterward side.

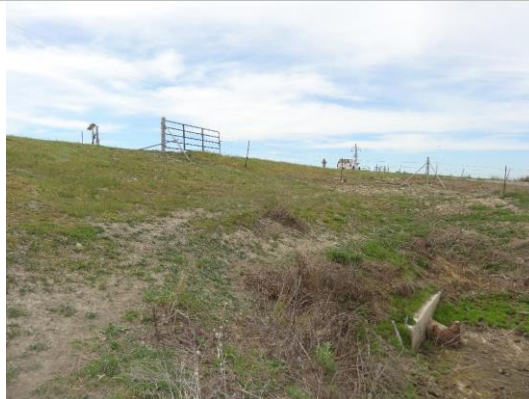
Photo 2 of 2 : UCIP_SP_2016_39480_66506.jpg

View of waterward side.

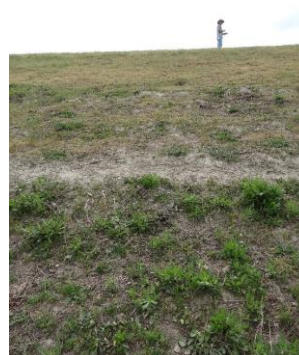
Photo 1 of 2 : UCIP_SP_2016_36663_66530.jpg

LM Start	15.82	Rating **	M	Issue No.	1242
LM End	15.82	Issue Type +	En	Location *	LS
Category	Supplemental			GPS Latitude/Longitude	
				Start	End
Item	DWR UCIP Field Study			37.155539 °	37.155539 °
				-120.615303 °	-120.615303 °
DWR ID					
Comment Code					
Inspector Comment					
FS_ID:36663 DS_ID:19885 EP_NO: N/A Repair Type: Non-Urgent Crossing Status: Found UCIP Comments: Need to contact owner to determine status of crossing. Waterward side is buried and not accessible. Landward side headwall is blocked by dense vegetation. Recommend confirming status of flap gate on waterward side and removing dense vegetation from landward side. FIELD_STRUCT_DESC: 36-inch CM pipe through levee, 16.6 feet below crown. Flap gate on the waterward end. (USACE-1967). This entry matches the Drainage or Irrigation Structure referenced in O&M manual (HLM 15.91). FS Date: 4/17/2014

View of waterward side, Photo 1 of 3.

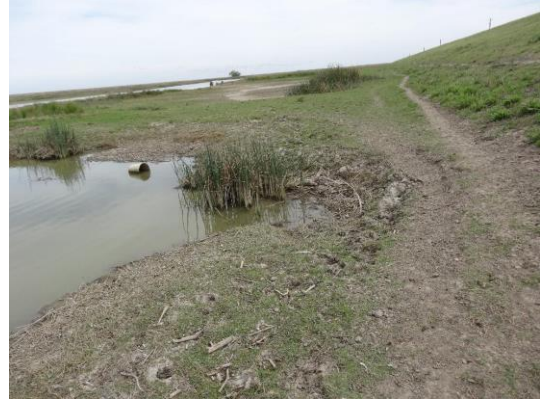
Photo 2 of 2 : UCIP_SP_2016_36663_66526.jpg

View of waterward side, photo 2 of 3.

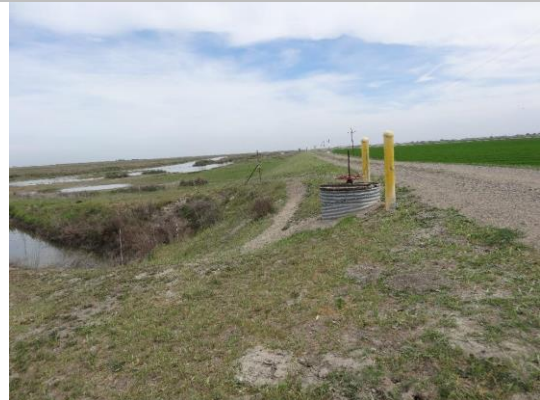
Photo 1 of 2 : UCIP_SP_2016_36665_66541.jpg

LM Start	16.40	Rating **	M	Issue No.	1243
LM End	16.40	Issue Type +	En	Location *	LS
Category	Supplemental			GPS Latitude/Longitude	
				Start	End
Item	DWR UCIP Field Study			37.149747 °	37.149747 °
				-120.607702 °	-120.607702 °
DWR ID					
Comment Code					
Inspector Comment					
FS_ID:36665					
DS_ID:19559					
EP_NO: N/A					
Repair Type: Non-Urgent					
Crossing Status: Found					
UCIP Comments: Need to contact owner to determine status of crossing. Unable to confirm pipe diameter.					
FIELD_STRUCT_DESC: 36-inch CM pipe through the levee, 5.9 feet below the crown. Slide gate on the waterward side. Siphon extends under channel. (USACE-1967). This entry matches the Drainage or Irrigation Structure referenced in O&M manual (HLM 16.49).					
FS Date: 4/17/2014

View of waterward side.

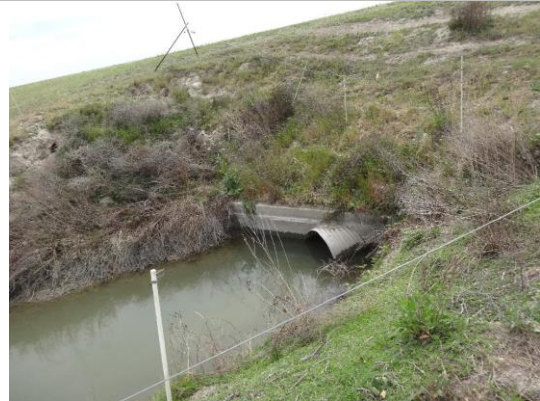
Photo 2 of 2 : UCIP_SP_2016_36665_66539.jpg

Concrete headwall and pipe visible on waterward side.

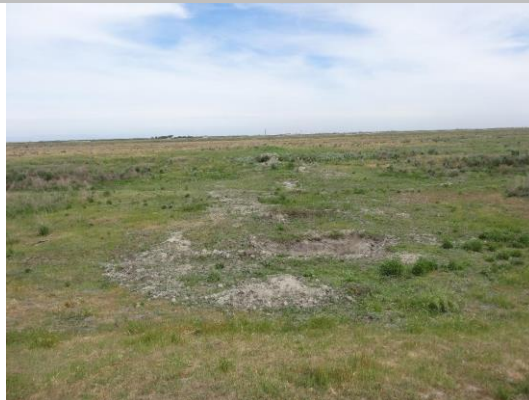
Photo 2 of 2 : UCIP_SP_2016_42941_66564.jpg

Overview of Eastside Bypass.

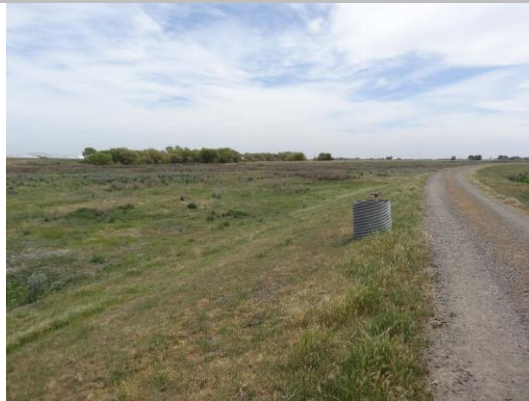
Photo 1 of 2 : UCIP_SP_2016_36687_66579.jpg

LM Start	18.89	Rating **	M	Issue No.	1244
LM End	18.89	Issue Type +	En	Location *	LS
Category	Supplemental			GPS Latitude/Longitude	
				Start	End
Item	DWR UCIP Field Study			37.118178 °	37.118178 °
				-120.586783 °	-120.586783 °
DWR ID					
Comment Code					
Inspector Comment					
FS_ID:36687 DS_ID:19889 EP_NO: N/A Repair Type: Non-Urgent Crossing Status: Found UCIP Comments: Dense vegetation limits the inspector's visibility to identify signs of pipe failure (leaks) along the landward slope. Recommend removing vegetation along pipe alignment to conduct proper inspection of structure. FIELD_STRUCT_DESC: 24-inch CM pipe through levee, 10.2 feet below crown. Slide gate in pipe riser on the waterward slope. (USACE-1967). This entry matches the Drainage or Irrigation Structure referenced in O&M manual (HLM 18.97). FS Date: 4/17/2014

View of waterward side.

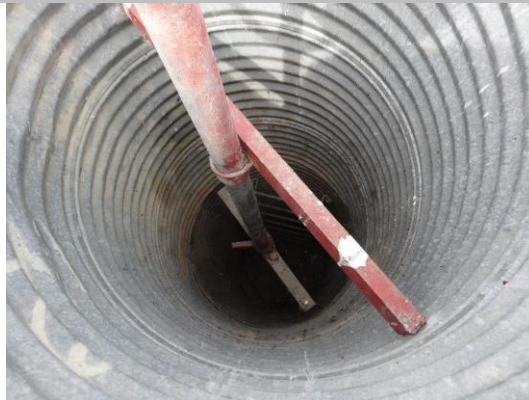
Photo 2 of 2 : UCIP_SP_2016_36687_66582.jpg

Inside view of CMP riser located on waterward slope.

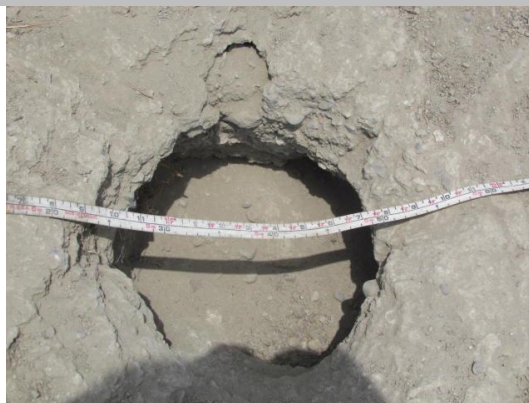
Photo 3 of 5 : SP_2016_NA0010_124_1211_20160512_00038.jpg

Looking at close-up view of large rodent hole on waterward slope. (Spring 2015)

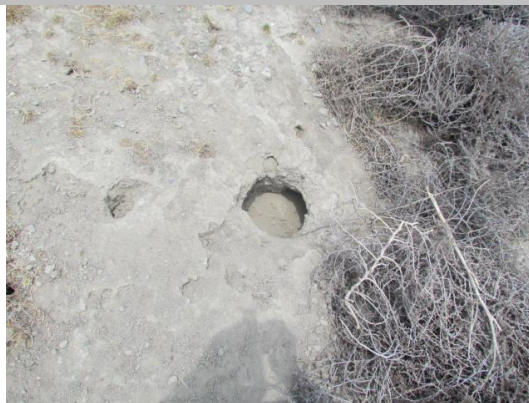
Photo 4 of 5 : SP_2016_NA0010_124_1211_20160512_00039.jpg

Looking at large rodent hole on waterward slope. Spring 2015

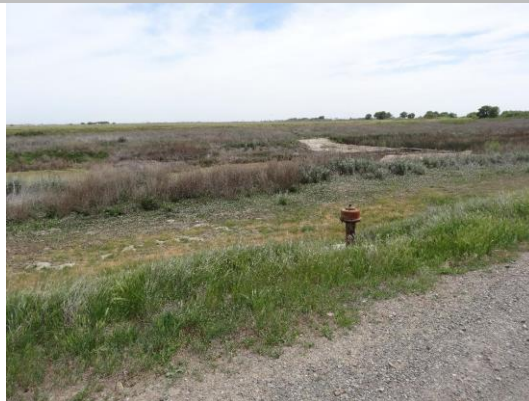
Photo 1 of 2 : UCIP_SP_2016_36688_66583.jpg

LM Start	19.28	Rating **	M	Issue No.	1245
LM End	19.28	Issue Type +	En	Location *	WS
Category	Supplemental			GPS Latitude/Longitude	
				Start	End
Item	DWR UCIP Field Study			37.112902 °	37.112902 °
				-120.588751 °	-120.588751 °
DWR ID					
Comment Code					
Inspector Comment					
FS_ID:36688 DS_ID:19890 EP_NO: N/A Repair Type: Non-Urgent Crossing Status: Found UCIP Comments: Dense vegetation limits the inspector's visibility to identify signs of pipe failure (leaks) along the slopes. Recommend removing vegetation along pipe alignment to conduct proper inspection of structure. FIELD_STRUCT_DESC: 48-inch CM pipe through levee, 20.0 feet below crown. Slide gate in pipe riser on the waterward slope. (USACE-1967). This entry matches the Drainage or Irrigation Structure referenced in O&M manual (HLM 19.36). Rip rap along landward slope. FS Date: 4/17/2014

View of waterward side.

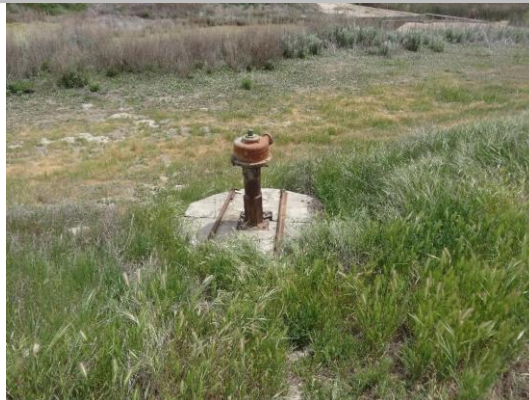
Photo 2 of 2 : UCIP_SP_2016_36688_66584.jpg

Riser located on waterward slope.

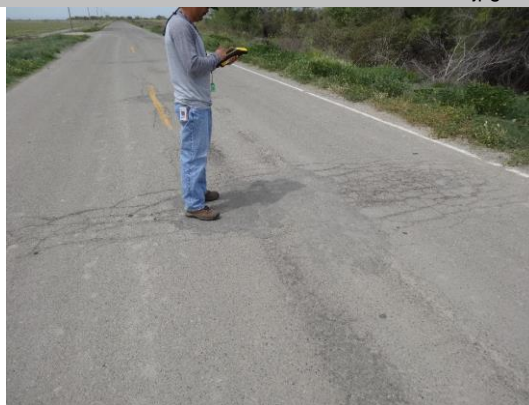
Photo 1 of 2 : UCIP_SP_2016_36689_66591.jpg

LM Start	19.94	Rating **	M	Issue No.	1217
LM End	19.94	Issue Type +	En	Location *	WS
Category	Supplemental			GPS Latitude/Longitude	
				Start	End
Item	DWR UCIP Field Study			37.113304 °	37.113304 °
				-120.579102 °	-120.579102 °
DWR ID					
Comment Code					
Inspector Comment					
FS_ID:36689 DS_ID:19891 EP_NO: N/A Repair Type: Non-Urgent Crossing Status: Found UCIP Comments: Dense vegetation limits the inspector's visibility to identify signs of pipe failure (leaks) along the slopes. Recommend removing vegetation along pipe alignment to conduct proper inspection of structure. FIELD_STRUCT_DESC: 2.5x2.5-foot R.C.B.C. through the levee, 14.0 feet below the crown. Flap gate on the waterward end. (USACE-1967). This entry matches the Drainage or Irrigation Structure referenced in O&M manual (HLM 19.85). FS Date: 4/17/2014

Overview of levee crown looking downstream.

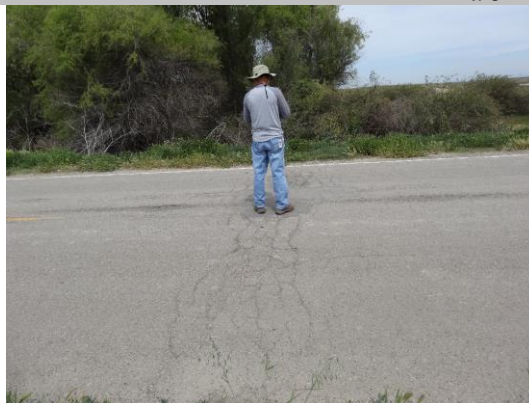
Photo 2 of 2 : UCIP_SP_2016_36689_66592.jpg

View of levee crown at crossing.

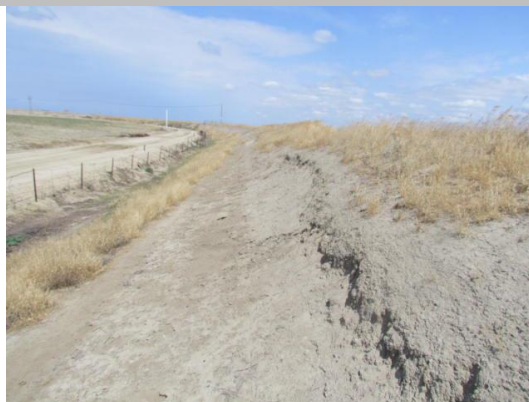
Photo 1 of 2 : SP_2016_NA0010_124_1209_20160512_00034.jpg

LM Start	20.79	Rating **	U	Issue No.	1209
LM End	20.88	Issue Type +	Ma	Location *	LS
Category	Earthen Levee			GPS Latitude/Longitude	
				Start	End
Item	Erosion / Bank Caving			37.113107 °	37.112176 °
				-120.563782 °	-120.562516 °
DWR ID	DWR_NA0010_06_s_2015_1209				
Comment Code					
E1 : Note and monitor erosion site.					
Inspector Comment					
Erosion on landward slope greater than 3 inches. Erosion caused by livestock.

Looking north at livestock erosion on landward slope.

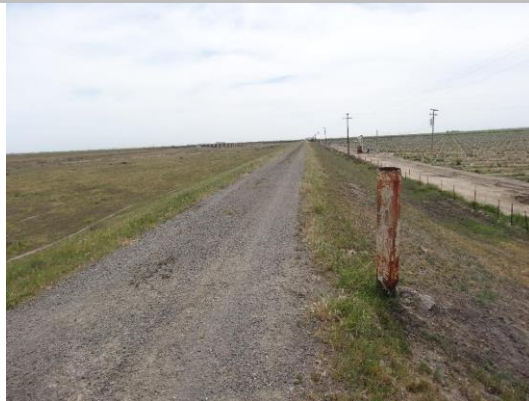
Photo 1 of 2 : UCIP_SP_2016_34010_61871.jpg

LM Start	24.02	Rating **	M	Issue No.	1213
LM End	24.02	Issue Type +	En	Location *	LS
Category	Supplemental			GPS Latitude/Longitude	
				Start	End
Item	DWR UCIP Field Study			37.077406 °	37.077406 °
				-120.525938 °	-120.525938 °
DWR ID					
Comment Code					
Inspector Comment					
FS_ID:34010					
DS_ID:19879					
EP_NO: 13638					
Repair Type: Non-Urgent					
Crossing Status: Found					
UCIP Comments: Need to contact owner to determine status. Crossing has been modified.					
FIELD_STRUCT_DESC: 16-inch steel pipe through levee, 3.5 feet below crown. Pump on the waterside. Siphon breaker on the landward shoulder. Cutoff wall around pipe at center of levee. Intake trench on waterward side. (Permit No. 13638-1984)					
FS Date: 4/17/2014

Overview of levee crown at crossing.

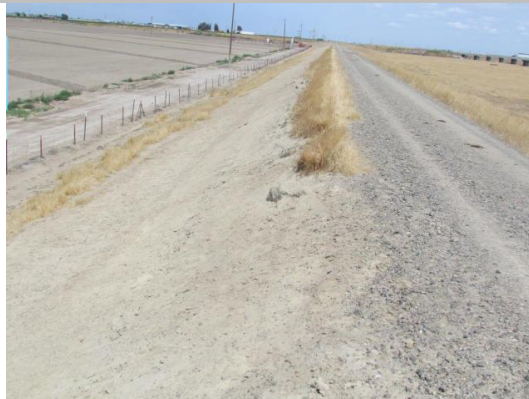
Photo 1 of 3 : SP_2016_NA0010_124_5_20160512_00007.jpg

LM Start	24.58	Rating **	M	Issue No.	5	
LM End	24.93	Issue Type +	Ma	Location *	LS	
Category	Earthen Levee			GPS Latitude/Longitude		
				Start		End
Item	Slope Stability			37.071198 °		°
				-120.519220 °		°
DWR ID	DWR_NA0010_06_s _ 2012_5					
Comment Code						
S2 : Repair the levee slope damaged by foot traffic and prevent access where possible.						
Inspector Comment						
Landside erosion caused by livestock.

Looking north at livestock erosion on landward slope. (Spring 2015)

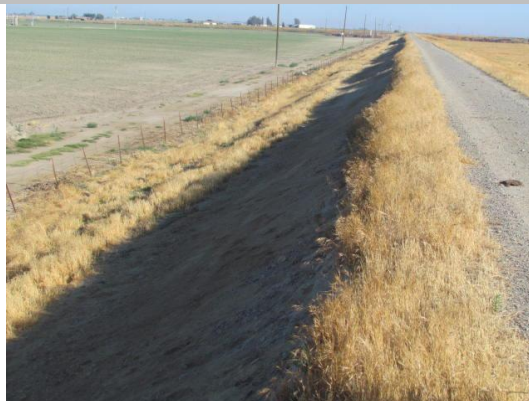
Photo 2 of 3 : SP_2016_NA0010_124_5_20160512_00008.jpg

Looking north at livestock erosion on landward slope. (Spring 2014)

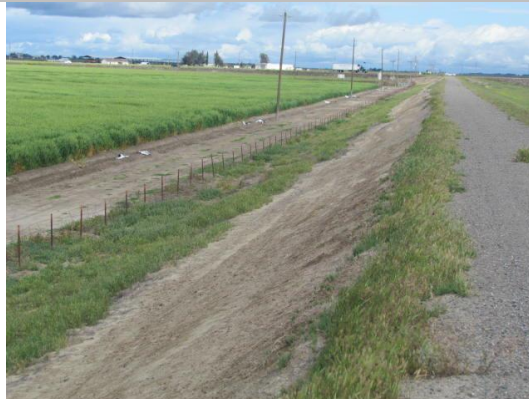
Photo 3 of 3 : SP_2016_NA0010_124_5_20160512_00009.jpg

Looking north at livestock erosion on landside slope. (Fall 2014)

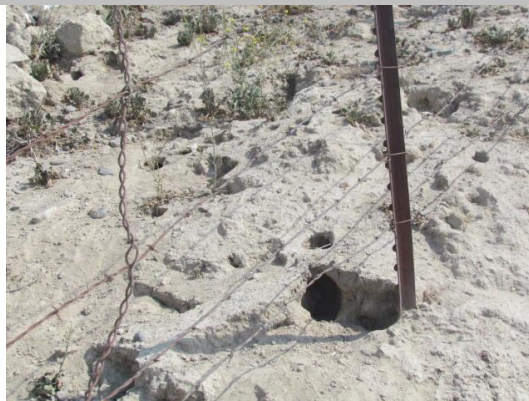
Photo 1 of 1 : SP_2016_NA0010_124_1208_20160512_00033.jpg

LM Start	26.13	Rating **	M	Issue No.	1208
LM End	26.13	Issue Type +	Ma	Location *	LS
Category	Earthen Levee			GPS Latitude/Longitude	
				Start	End
Item	Animal Control			37.054222 °	37.054222 °
				-120.500862 °	-120.500862 °
DWR ID	DWR_NA0010_06_s _ 2015_1208				
Comment Code					
A1 : Exterminate rodents and backfill and compact or grout burrows.					
Inspector Comment					
Noted several rodent holes next to and within rock revertment on landward slope.

Looking northeast at several rodent holes on landward slope.

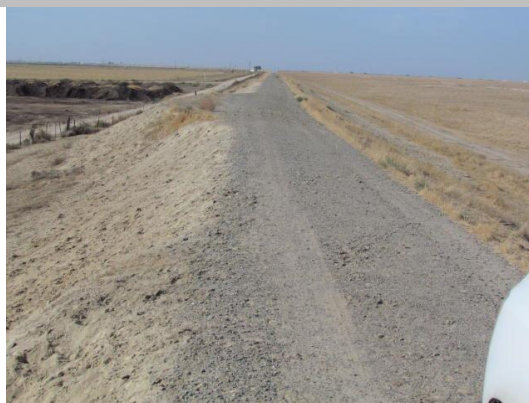
Photo 1 of 4 : SP_2016_NA0010_124_3_20160512_00003.jpg

LM Start	27.64	Rating **	M	Issue No.	3
LM End	27.97	Issue Type +	Ma	Location *	LS
Category	Earthen Levee			GPS Latitude/Longitude	
				Start	End
Item	Slope Stability			37.036955 °	37.032887 °
				-120.484395 °	-120.481225 °
DWR ID	DWR_NA0010_06_s _ 2012_3				
Comment Code					
S2 : Repair the levee slope damaged by foot traffic and prevent access where possible.					
Inspector Comment					
Landside erosion caused by livestock. Erosion greater than 3" in depth on landward slope. Levee crown has narrowed within this reach.

Looking north at livestock erosion on landward slope. Fall 2015

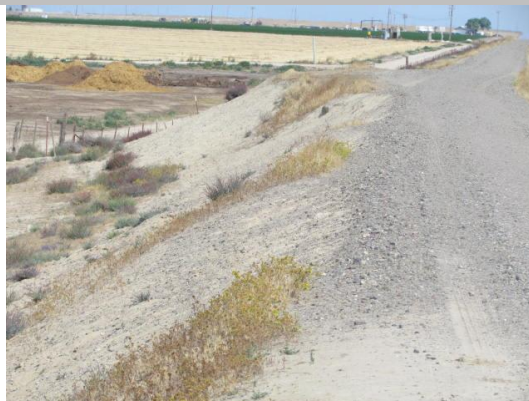
Photo 2 of 4 : SP_2016_NA0010_124_3_20160512_00004.jpg

Looking north at livestock erosion on landward shoulder and slope.(Spring 2015)

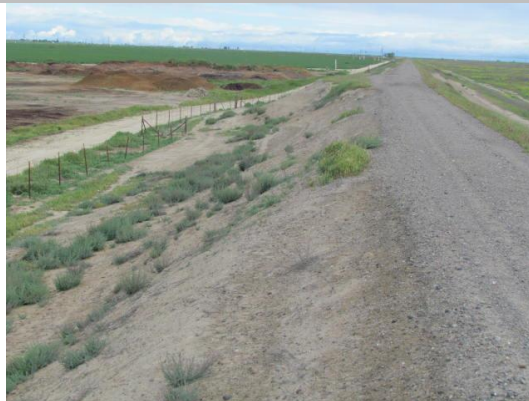
Photo 3 of 4 : SP_2016_NA0010_124_3_20160512_00005.jpg

Looking north at livestock erosion on landside shoulder and slope. (Fall 2014)

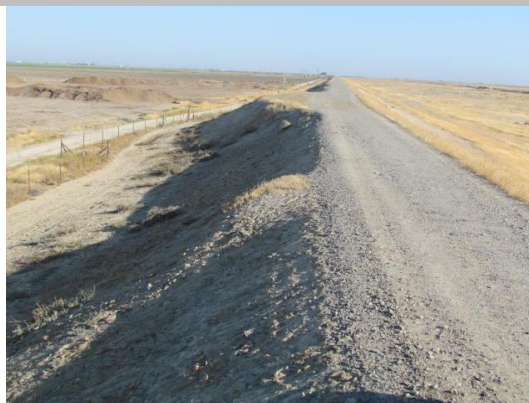
Photo 4 of 4 : SP_2016_NA0010_124_3_20160512_00006.jpg

Looking north at livestock erosion on landward slope. (Spring 2013)

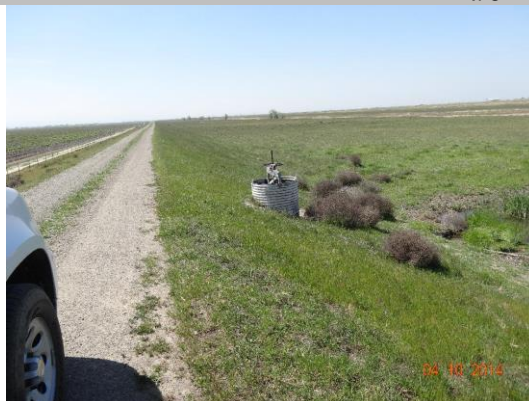
Photo 1 of 2 : UCIP_SP_2016_39886_66600.jpg

Comment Code					
Inspector Comment					
FS_ID:39886 DS_ID:19881 EP_NO: N/A Repair Type: Non-Urgent Crossing Status: Found UCIP Comments: Dense vegetation limits the inspector's visibility to identify signs of pipe failure (leaks) along the slopes. Recommend removing vegetation along pipe alignment to conduct proper inspection of structure. FIELD_STRUCT_DESC: 36-inch CM pipe through levee, 12.4 feet below crown. Slide gate in 48-inch CM pipe riser in the waterward slope. Concrete "U" headwall on both ends. Cobble pad on the landward side. (USACE-1967). This entry matches the Drainage or Irrigation Structure referenced in O&M manual (HLM 29.34). FS Date: 4/10/2014

View of waterward side--slide gate inside CMP riser located on waterward slope.

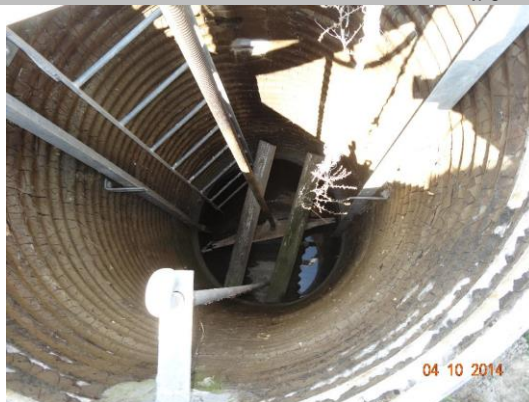
Photo 2 of 2 : UCIP_SP_2016_39886_66603.jpg

Inside view of CMP riser located on waterward slope.

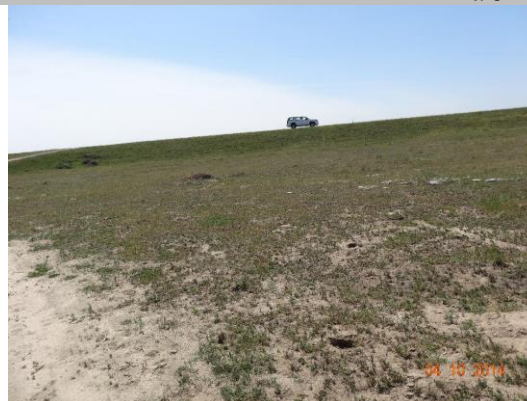
Photo 1 of 2 : UCIP_SP_2016_36693_66607.jpg

Comment Code					
Inspector Comment					
FS_ID:36693 DS_ID:19882 EP_NO: N/A Repair Type: Non-Urgent Crossing Status: Found UCIP Comments: Altered crossing--steel pipe section on landward side and concrete pipe section on waterward side. Joints on waterward side seperated. Need to contact owner to determine status. FIELD_STRUCT_DESC: [Rodunder Siphon Structure] 48-inch R.C. siphon pipe through the levee, 14.5 feet below the crown. Concrete "U" headwall on outlet structure on the landward end. Slide gate mounted on the headwall. (USACE-1967). This entry matches the Drainage or Irrigation Structure referenced in O&M manual (HLM 30.27). FS Date: 4/10/2014

Overview of waterward side.

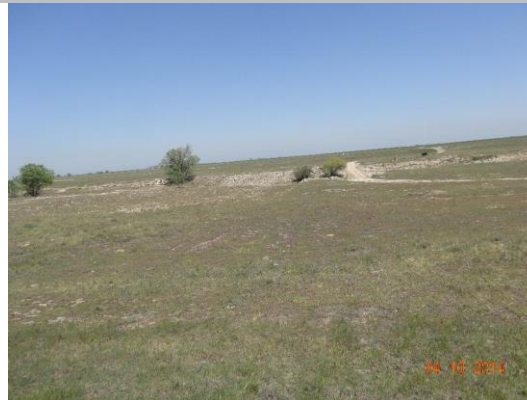
Photo 2 of 2 : UCIP_SP_2016_36693_66604.jpg

Overview of Eastside Bypass at crossing.

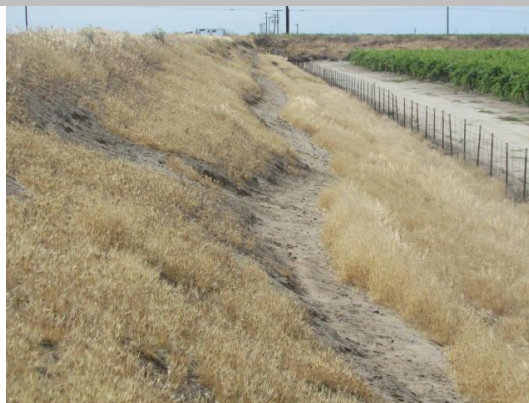
Photo 2 of 2 : SP_2016_NA0010_124_1207_20160512_00032.jpg

LM Start	30.81	Rating **	U	Issue No.	1207
LM End	31.06	Issue Type +	Ma	Location *	LS
Category	Earthen Levee			GPS Latitude/Longitude	
				Start	End
Item	Erosion / Bank Caving			37.021615 °	37.018428 °
				-120.437587 °	-120.435378 °
DWR ID	DWR_NA0010_06_s _ 2015_1207				
Comment Code					
E1 : Note and monitor erosion site.					
Inspector Comment					
Landward erosion greater than 1" in depth and greater than 3" in length. Erosion caused by livestock traffic.

Looking south at livestock erosion on landward slope.

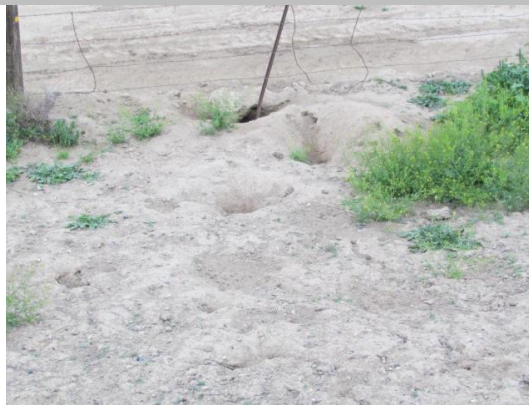
Photo 1 of 2 : SP_2016_NA0010_124_2_20160512_00001.jpg

LM Start	31.10	Rating **	U	Issue No.	2
LM End	31.10	Issue Type +	Ma	Location *	LS
Category	Earthen Levee			GPS Latitude/Longitude	
				Start	End
Item	Animal Control			37.017955 °	37.017955 °
				-120.435017 °	-120.435017 °
DWR ID	DWR_NA0010_06_s _ 2012_2				
Comment Code					
A1 : Exterminate rodents and backfill and compact or grout burrows.					
Inspector Comment

Looking west at rodent holes on landside slope and toe near fence line.

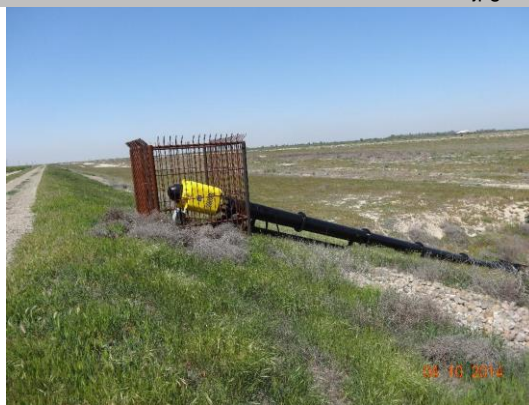
Photo 1 of 2 : UCIP_SP_2016_46183_61898.jpg

LM Start	33.08	Rating **	M	Issue No.	1261
LM End	33.08	Issue Type +	En	Location *	LS
Category	Supplemental			GPS Latitude/Longitude	
				Start	End
Item	DWR UCIP Field Study			36.995672 °	36.995672 °
				-120.412919 °	-120.412919 °
DWR ID					
Comment Code					
Inspector Comment					
FS_ID:46183 DS_ID:19883 EP_NO: 6416A Repair Type: Non-Urgent Crossing Status: Found UCIP Comments: Crossing updated--need to contact owner to determine permit issued by CVFPB for authorized changes. FIELD_STRUCT_DESC: 20-inch (not 18 inch as mentioned in DS study) steel pipe through the levee, 3.9 feet below crown. Electrical conduit through levee. Capped with welded plate on landward end. Siphon breaker on apex of pipe on the landward shoulder. Cutoff wall around pipe at centerline of levee. Slant pump on waterward slope. (Permit No. 6416A-1980) FS Date: 4/10/2014

View of waterward side--pipe and pump fenced off on waterward slope.

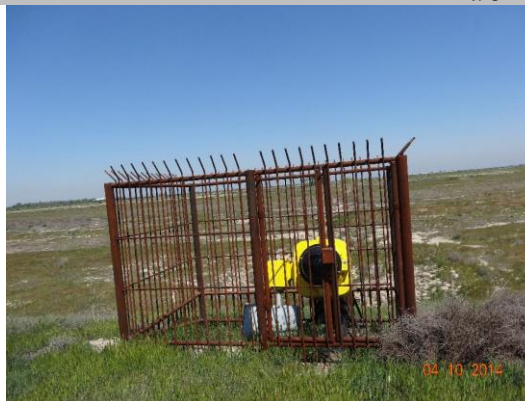
Photo 2 of 2 : UCIP_SP_2016_46183_61902.jpg

LM Start	33.08	Rating **	M	Issue No.	1261 (cont)	
LM End	33.08	Issue Type +	En	Location *	LS	
Category	Supplemental			GPS Latitude/Longitude		
				Start		End
Item	DWR UCIP Field Study			36.995672 °		36.995672 °
				-120.412919 °		-120.412919 °
DWR ID						
Comment Code						
Inspector Comment						
FS_ID:46183 DS_ID:19883 EP_NO: 6416A Repair Type: Non-Urgent Crossing Status: Found UCIP Comments: Crossing updated--need to contact owner to determine permit issued by CVFPB for authorized changes. FIELD_STRUCT_DESC: 20-inch (not 18 inch as mentioned in DS study) steel pipe through the levee, 3.9 feet below crown. Electrical conduit through levee. Capped with welded plate on landward end. Siphon breaker on apex of pipe on the landward shoulder. Cutoff wall around pipe at centerline of levee. Slant pump on waterward slope. (Permit No. 6416A-1980) FS Date: 4/10/2014

Electrical conduit visible on waterward slope.

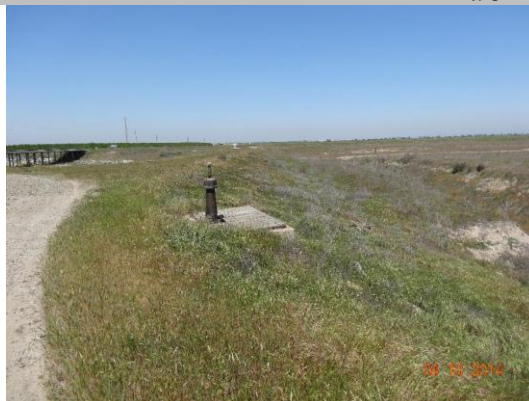
Photo 1 of 2 : UCIP_SP_2016_39481_66628.jpg

Comment Code					
Inspector Comment					
FS_ID:39481 DS_ID:19813 EP_NO: N/A Repair Type: Non-Urgent Crossing Status: Found UCIP Comments: Dense vegetation limits the inspector's visibility to identify signs of pipe failure (leaks) along the slope. Recommend removing vegetation along pipe alignment to conduct proper inspection of structure and appurtenances. High vegetation along crossing alignment--recommend removing vegetation along pipe crossing. FIELD_STRUCT_DESC: 48x72-inch through the levee, 15.1 feet below the crown. Slide gate in concrete riser in the waterward slope. Concrete "U" headwall on both ends. Landside channel cobble revetted for 8.0 feet. (USACE-1967). This entry matches the Drainage or Irrigation Structure referenced in O&M manual (HLM 35.33). FS Date: 4/10/2014

View of waterward side--slide gate inside concrete box.

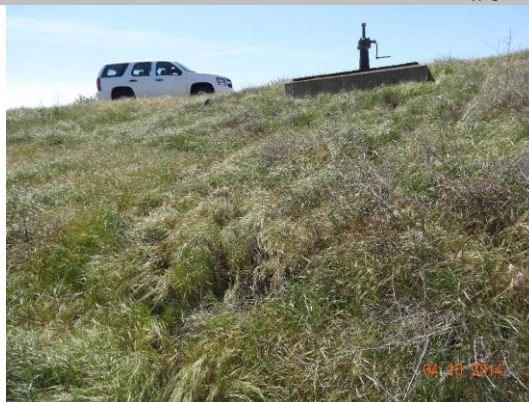
Photo 2 of 2 : UCIP_SP_2016_39481_66632.jpg

View of waterward slope covered by dense vegetation.

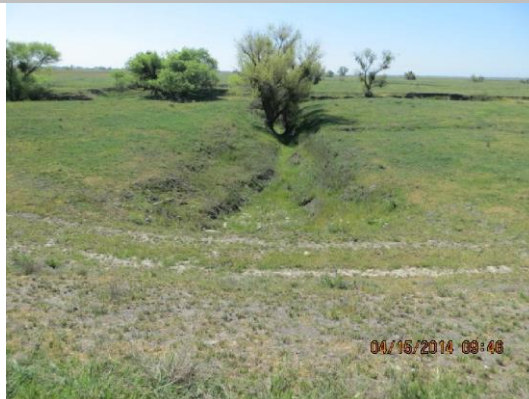
Photo 1 of 2 : UCIP_SP_2016_41131_60954.jpg

LM Start	0.07	Rating **	U	Issue No.	191
LM End	0.07	Issue Type +	En	Location *	WS
Category	Supplemental			GPS Latitude/Longitude	
				Start	End
Item	DWR UCIP Field Study			37.255897°	37.255897°
				-120.771127°	-120.771127°
DWR ID					
Comment Code					
Inspector Comment					
FS_ID:41131 DS_ID:19892 EP_NO: N/A Repair Type: Urgent Crossing Status: Found UCIP Comments: Flapgate partially blocked by soil buildup at WS toe. FIELD_STRUCT_DESC: 24-inch C.M stormdrain pipe through the levee, 10.8 feet below the crown. Flap gate on the waterward end. Concrete headwall on the landward end. Concrete "U" headwall on the waterward end. (USACE-1967). This entry matches the Drainage or Irrigation Structure referenced in O&M manual (HLM 0.07). FS Date: 4/15/2014

Pipe and headwall at WS toe.

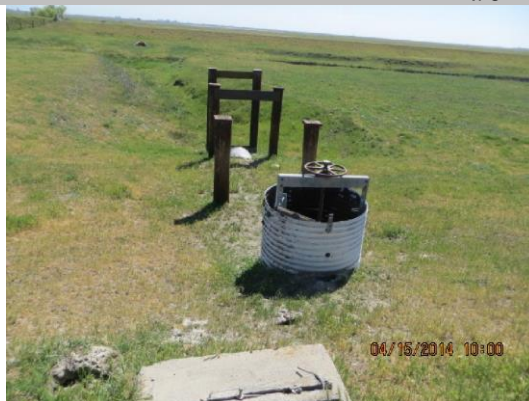
Photo 1 of 2 : UCIP_SP_2016_33713_60963.jpg

Comment Code					
Inspector Comment					
FS_ID:33713					
DS_ID:19894					
EP_NO: N/A					
Repair Type: Non-Urgent					
Crossing Status: Found					
UCIP Comments: Slide gate not operable, but left in closed position.					
Need to reinstall covers over slide gate standpipe.					
FIELD_STRUCT_DESC: 36-inch C.M stormdrain pipe through the					
levee, 9.7 feet below the crown. Slide gate in 48-inch C.M. pipe riser in					
the landward slope. Concrete "U" headwall on the landward end, inlet					
channel cobble revetted. Dilapidated wooden pier on WS. Waterward					
slope and outlet ditch cobble revetted. (USACE-1967). This entry					
matches the Drainage or Irrigation Structure referenced in O&M manual					
(HLM 0.49).					
FS Date: 4/15/2014

Slide gate in CMP riser on WS slope.

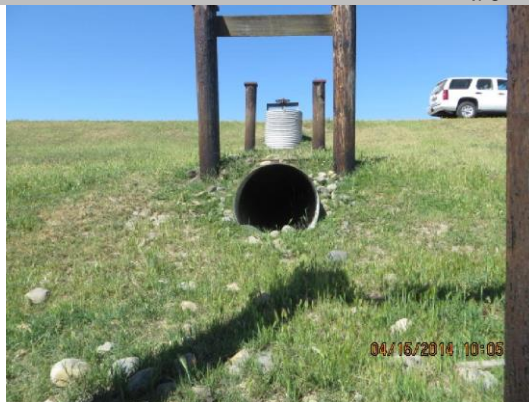
Photo 2 of 2 : UCIP_SP_2016_33713_60965.jpg

Outlet on WS slope.
