**Flood Control Project Maintenance
Levee Inspections****LMA District Cover Sheet****Spring 2016 Levee Inspection Results****Lower San Joaquin Levee District**

Spring 2016 Levee Inspection Results

Lower San Joaquin Levee District

Waterway			Bank	Unit Miles
Unit No. 01 San Joaquin River			Right	22.52
	Spring (March - May)	Summer (June - August)	(September - November) Fall	Winter (December - February)
Unit Maintenance Rating (Fall Only)				
Date of Inspection	5/16/2016 - 5/19/2016			
DWR Inspector	Richard Willoughby			
Accompanied By

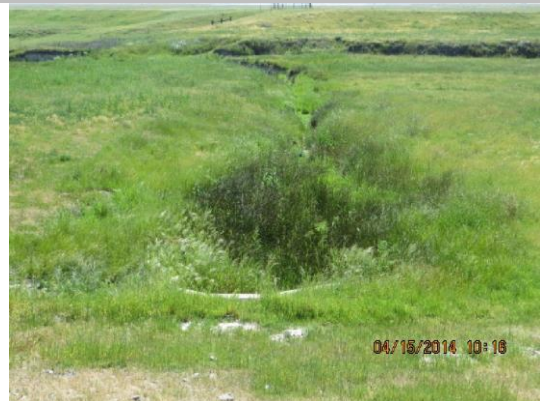
Photo 1 of 2 : UCIP_SP_2016_39507_60986.jpg

LM Start	0.85	Rating **	M	Issue No.	189
LM End	0.85	Issue Type +	En	Location *	LS
Category	Supplemental			GPS Latitude/Longitude	
				Start	End
Item	DWR UCIP Field Study			37.262981 °	37.262981 °
				-120.761703 °	-120.761703 °
DWR ID					
Comment Code					
Inspector Comment					
FS_ID:39507 DS_ID:19896 EP_NO: N/A Repair Type: Non-Urgent Crossing Status: Found UCIP Comments: Need to contact owner. Heavy sediment buildup at inlet due to animal activity should be cleared. FIELD_STRUCT_DESC: 24-inch C.M. stormdrain pipe through the levee, 9.8-feet below the crown. Flap gate on the waterward end. Wooden weir on concrete headwall at the LS toe. 36-inch concrete riser at LS toe. Concrete "U" headwall on the waterward end. Concrete standpipe on landward side. (USACE-1967). This entry matches the Drainage or Irrigation Structure referenced in O&M manual (HLM 0.85). FS Date: 4/15/2014

Headwall and flapgate on WS toe.

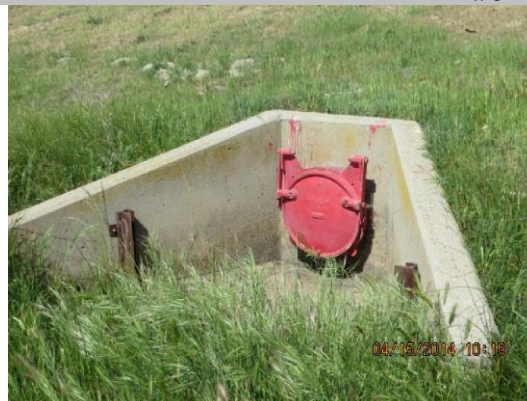
Photo 2 of 2 : UCIP_SP_2016_39507_60988.jpg

Item	DWR UCIP Field Study			37.262981 °	37.262981 °	
				-120.761703 °	-120.761703 °	
DWR ID						
Comment Code						
Inspector Comment						
FS_ID:39507						
DS_ID:19896						
EP_NO: N/A						
Repair Type: Non-Urgent						
Crossing Status: Found						
UCIP Comments: Need to contact owner. Heavy sediment buildup at inlet due to animal activity should be cleared.						
FIELD_STRUCT_DESC: 24-inch C.M. stormdrain pipe through the levee, 9.8-feet below the crown. Flap gate on the waterward end. Wooden weir on concrete headwall at the LS toe. 36-inch concrete riser at LS toe. Concrete "U" headwall on the waterward end. Concrete standpipe on landward side. (USACE-1967). This entry matches the Drainage or Irrigation Structure referenced in O&M manual (HLM 0.85). FS Date: 4/15/2014

Headwall and flapgate on WS toe.

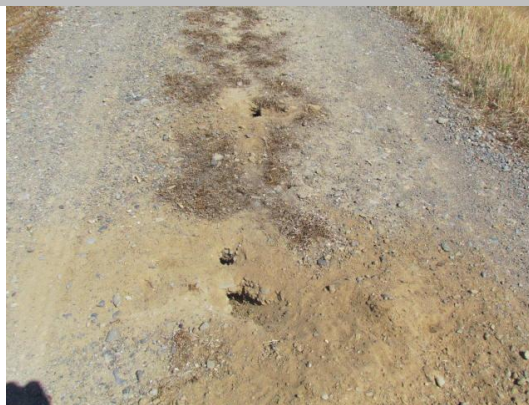
Photo 1 of 1 : SP_2016_NA0010_125_187_20160512_00012.jpg

LM Start	1.94	Rating **	A/W	Issue No.	187
LM End	1.94	Issue Type +	Ma	Location *	CR
Category	Earthen Levee			GPS Latitude/Longitude	
				Start	End
Item	Animal Control			37.261032 °	37.261032 °
				-120.743705 °	-120.743705 °
DWR ID	DWR_NA0010_07_s _ 2015_187				
Comment Code					
A3 : No rodents visible, but rodent burrows visible; need to backfill and compact or grout burrows.					
Inspector Comment

Looking at several rodent holes on levee crown.

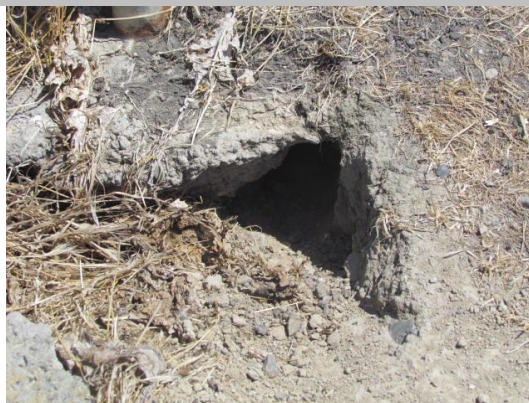
Photo 2 of 2 : SP_2016_NA0010_125_12_20160523_00025.jpg

LM Start	2.09	Rating **	M	Issue No.	12
LM End	2.09	Issue Type +	Ma	Location *	LS
Category	Earthen Levee			GPS Latitude/Longitude	
				Start	End
Item	Animal Control			37.259187 °	37.259187 °
				-120.742551 °	-120.742551 °
DWR ID	DWR_NA0010_07_f_2014_12				
Comment Code					
A3 : No rodents visible, but rodent burrows visible; need to backfill and compact or grout burrows.					
Inspector Comment					
Rodent activity noted next to fence post.

Looking at rodent activity next to fence post

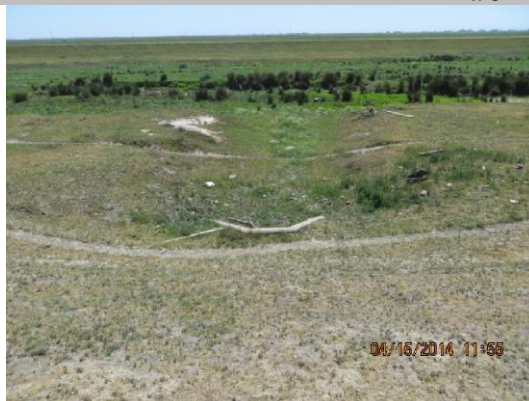
Photo 1 of 2 : UCIP_SP_2016_39508_61016.jpg

LM Start	3.09	Rating **	M	Issue No.	190
LM End	3.09	Issue Type +	En	Location *	LS
Category	Supplemental			GPS Latitude/Longitude	
				Start	End
Item	DWR UCIP Field Study			37.251883 °	37.251883 °
				-120.728264 °	-120.728264 °
DWR ID					
Comment Code					
Inspector Comment					
FS_ID:39508 DS_ID:19901 EP_NO: N/A Repair Type: Non-Urgent Crossing Status: Found UCIP Comments: Some sediment buildup at landward toe and inside pipe--recommend clearing. FIELD_STRUCT_DESC: 24-inch C.M. stormdrain pipe through the levee, 10.4-feet below the crown. Flap gate on the waterward end. Concrete headwall on the landward end. Concrete "U" headwall on the waterward end. (USACE-1967). This entry matches the Drainage or Irrigation Structure referenced in O&M manual (HLM 3.09). FS Date: 4/15/2014

Headwall, pipe, and flapgate on WS toe.

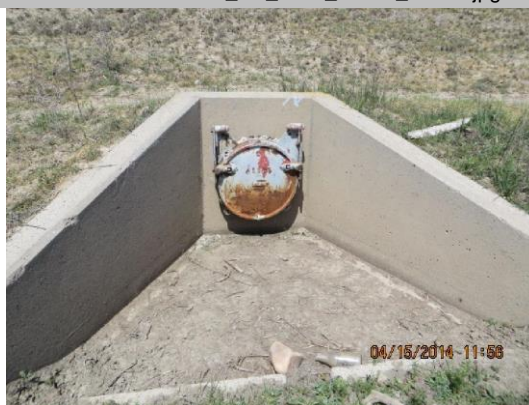
Photo 2 of 2 : UCIP_SP_2016_39508_61015.jpg

Headwall, pipe, and flapgate on WS toe.

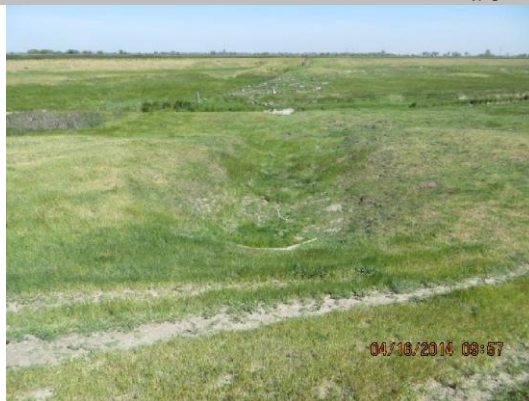
Photo 1 of 2 : UCIP_SP_2016_39887_61084.jpg

FS_ID:39887
DS_ID:19832
EP_NO: N/A
Repair Type: Non-Urgent
Crossing Status: Found
UCIP Comments: Some sediment buildup at inlet on LS toe.
FIELD_STRUCT_DESC: 24-inch CM stormdrain pipe through levee, 11.5 feet below crown. Flap gate on the waterward end. Concrete headwalls. (USACE-1967). This entry matches the Drainage or Irrigation Structure referenced in O&M manual (HLM 0.89).
FS Date: 4/16/2014

Headwall, pipe, and flapgate on WS toe.

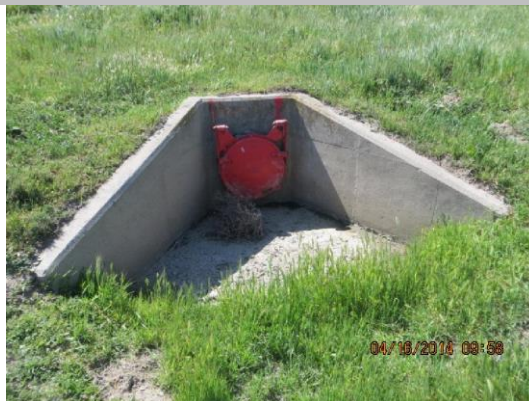
Photo 2 of 2 : UCIP_SP_2016_39887_61083.jpg

Headwall, pipe, and flapgate on WS toe.

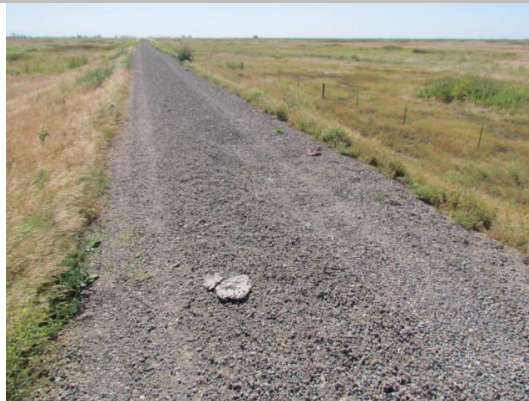
Photo 1 of 1 : SP_2016_NA0010_126_5_20160523_00025.jpg

LM Start	1.16	Rating **	M	Issue No.	5
LM End	1.16	Issue Type +	Ma	Location *	CR
Category	Earthen Levee			GPS Latitude/Longitude	
				Start	End
Item	Crown Surface / Depressions / Rutting			37.263243 °	37.263243 °
				-120.756372 °	-120.756372 °
DWR ID	DWR_NA0010_08_s _ 2016_5				
Comment Code					
C2 : Repair depressions or ruts in the crown or slope.					
Inspector Comment					
Depression noted on levee crown.

Looking west at depression on toward landward shoulder.

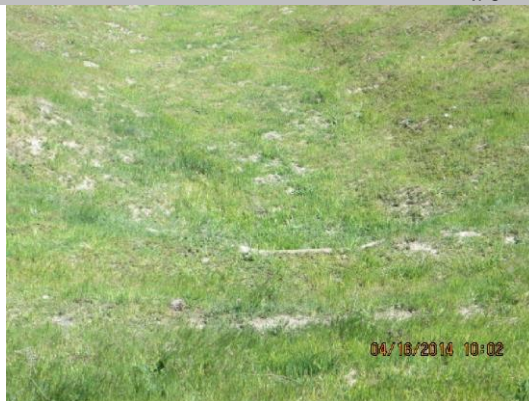
Photo 1 of 2 : UCIP_SP_2016_39509_61090.jpg

LM Start	1.21	Rating **	M	Issue No.	16
LM End	1.21	Issue Type +	En	Location *	LS
Category	Supplemental			GPS Latitude/Longitude	
				Start	End
Item	DWR UCIP Field Study			37.263188 °	37.263188 °
				-120.755399 °	-120.755399 °
DWR ID					
Comment Code					
Inspector Comment					
FS_ID:39509 DS_ID:19833 EP_NO: N/A Repair Type: Non-Urgent Crossing Status: Found UCIP Comments: Debris blocking landward headwall--recommend clearing. FIELD_STRUCT_DESC: 24-inch CM stormdrain pipe through levee, 11.6 feet below crown. Flap gate on the waterward end. Concrete headwalls. (USACE-1967). This entry matches the Drainage or Irrigation Structure referenced in O&M manual (HLM 1.21). FS Date: 4/16/2014

Concrete headwall, pipe, and flapgate on WS toe.

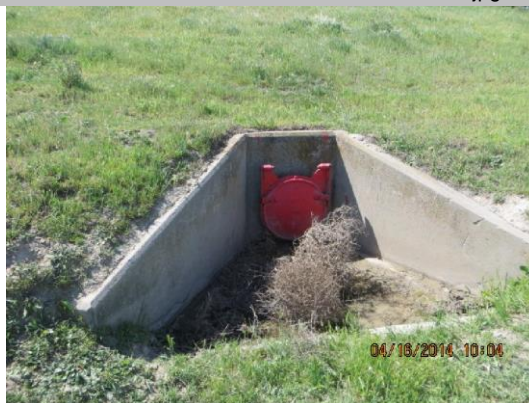
Photo 2 of 2 : UCIP_SP_2016_39509_61091.jpg

Concrete headwall, pipe, and flapgate on WS toe.

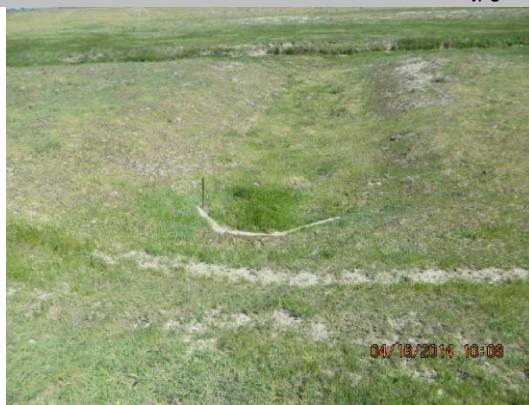
Photo 1 of 2 : UCIP_SP_2016_39510_61094.jpg

LM Start	1.38	Rating **	M	Issue No.	17
LM End	1.38	Issue Type +	En	Location *	LS
Category	Supplemental			GPS Latitude/Longitude	
				Start	End
Item	DWR UCIP Field Study			37.263194 °	37.263194 °
				-120.752299 °	-120.752299 °
DWR ID					
Comment Code					
Inspector Comment					
FS_ID:39510 DS_ID:19834 EP_NO: N/A Repair Type: Non-Urgent Crossing Status: Found UCIP Comments: Animal burrows along pipe alignment on LS. Some sediment buildup at LS toe and inside pipe--recommend clearing. FIELD_STRUCT_DESC: 24-inch CM stormdrain pipe through levee, 11.5 feet below crown. Flap gate on the waterward end. Concrete headwall on both ends. (USACE-1967). This entry matches the Drainage or Irrigation Structure referenced in O&M manual (HLM 1.38). FS Date: 4/16/2014

Pipe, headwall, and flapgate on WS toe.

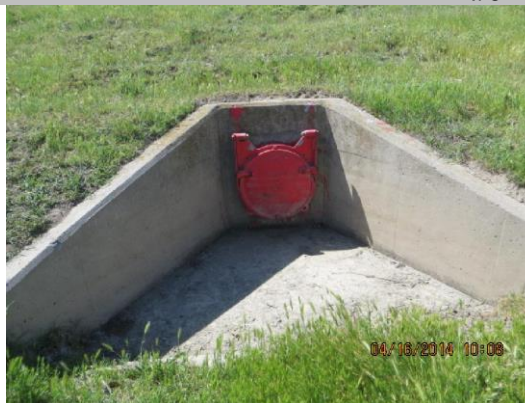
Photo 2 of 2 : UCIP_SP_2016_39510_61093.jpg

LM Start	1.38	Rating **	M	Issue No.	17 (cont)
LM End	1.38	Issue Type +	En	Location *	LS
Category	Supplemental			GPS Latitude/Longitude	
				Start	End
Item	DWR UCIP Field Study			37.263194 °	37.263194 °
				-120.752299 °	-120.752299 °
DWR ID					
Comment Code					
Inspector Comment					
FS_ID:39510 DS_ID:19834 EP_NO: N/A Repair Type: Non-Urgent Crossing Status: Found UCIP Comments: Animal burrows along pipe alignment on LS. Some sediment buildup at LS toe and inside pipe--recommend clearing. FIELD_STRUCT_DESC: 24-inch CM stormdrain pipe through levee, 11.5 feet below crown. Flap gate on the waterward end. Concrete headwall on both ends. (USACE-1967). This entry matches the Drainage or Irrigation Structure referenced in O&M manual (HLM 1.38). FS Date: 4/16/2014

Pipe, headwall, and flapgate on WS toe.

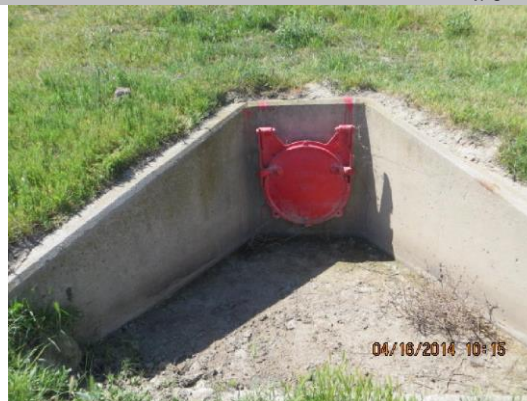
Photo 1 of 2 : UCIP_SP_2016_39511_61098.jpg

LM Start	2.05	Rating **	M	Issue No.	18
LM End	2.05	Issue Type +	En	Location *	WS
Category	Supplemental			GPS Latitude/Longitude	
				Start	End
Item	DWR UCIP Field Study			37.258220 °	37.258220 °
				-120.742868 °	-120.742868 °
DWR ID					
Comment Code					
Inspector Comment					
FS_ID:39511 DS_ID:19835 EP_NO: N/A Repair Type: Non-Urgent Crossing Status: Found UCIP Comments: Non-functional landward inlet is buried in sediment. Need to contact owner to determine status. FIELD_STRUCT_DESC: 24-inch CM stormdrain pipe through levee, 12.0 feet below crown. Flap gate on the waterward end. Concrete headwall on both ends. (USACE-1967). This entry matches the Drainage or Irrigation Structure referenced in O&M manual (HLM 2.05). FS Date: 4/16/2014

Pipe, headwall, and flapgate on Ws toe.

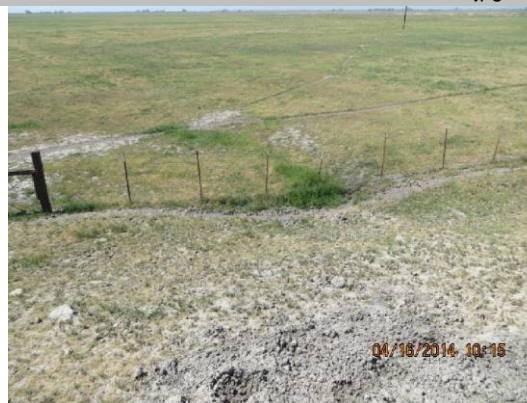
Photo 2 of 2 : UCIP_SP_2016_39511_61099.jpg

Pipe and headwall buried in sediment at LS toe.

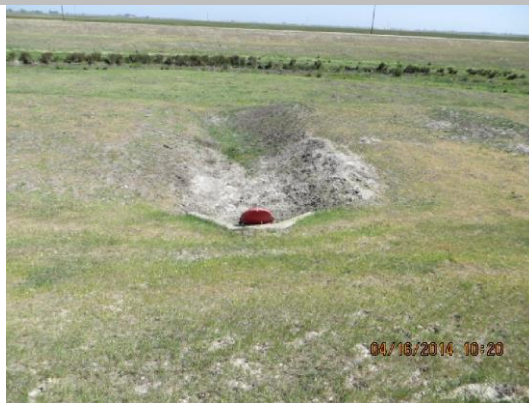
Photo 1 of 2 : UCIP_SP_2016_39512_61102.jpg

LM Start	2.12	Rating **	M	Issue No.	19
LM End	2.12	Issue Type +	En	Location *	LS
Category	Supplemental			GPS Latitude/Longitude	
				Start	End
Item	DWR UCIP Field Study			37.257800 °	37.257800 °
				-120.741604 °	-120.741604 °
DWR ID					
Comment Code					
Inspector Comment					
FS_ID:39512 DS_ID:19836 EP_NO: N/A Repair Type: Non-Urgent Crossing Status: Found UCIP Comments: Sediment buildup in pipe visible from landward side. FIELD_STRUCT_DESC: 24-inch CM stormdrain pipe through levee, 9.5- feet below crown. Flap gate on the waterward end. Concrete headwall on both ends. (USACE-1967). This entry matches the Drainage or Irrigation Structure referenced in O&M manual (HLM 2.12). FS Date: 4/16/2014

Pipe, headwall, and flapgate on WS toe.

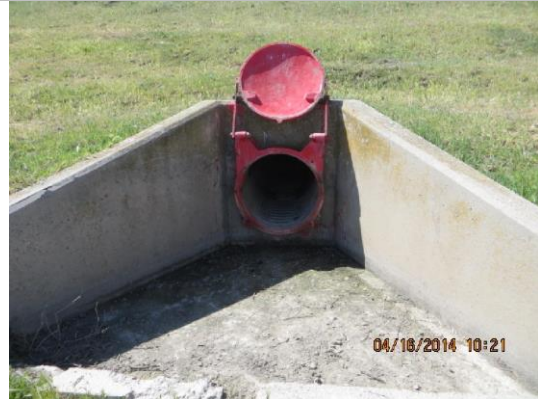
Photo 2 of 2 : UCIP_SP_2016_39512_61100.jpg

LM Start	2.12	Rating **	M	Issue No.	19 (cont)	
LM End	2.12	Issue Type +	En	Location *	LS	
Category	Supplemental			GPS Latitude/Longitude		
				Start	End	
Item	DWR UCIP Field Study			37.257800 °	37.257800 °	
				-120.741604 °	-120.741604 °	
DWR ID						
Comment Code						
Inspector Comment						
FS_ID:39512 DS_ID:19836 EP_NO: N/A Repair Type: Non-Urgent Crossing Status: Found UCIP Comments: Sediment buildup in pipe visible from landward side. FIELD_STRUCT_DESC: 24-inch CM stormdrain pipe through levee, 9.5- feet below crown. Flap gate on the waterward end. Concrete headwall on both ends. (USACE-1967). This entry matches the Drainage or Irrigation Structure referenced in O&M manual (HLM 2.12). FS Date: 4/16/2014

Pipe, headwall, and flapgate on WS toe.

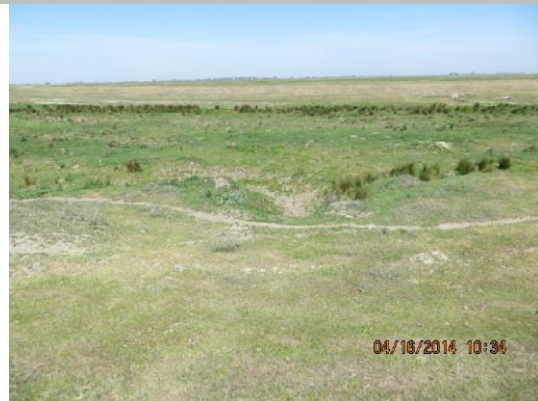
Photo 1 of 2 : UCIP_SP_2016_42853_61112.jpg

LM Start	3.06	Rating **	U	Issue No.	21
LM End	3.06	Issue Type +	En	Location *	LS
Category	Supplemental			GPS Latitude/Longitude	
				Start	End
Item	DWR UCIP Field Study			37.250864 °	37.250864 °
				-120.728151 °	-120.728151 °
DWR ID					
Comment Code					
Inspector Comment					
FS_ID:42853 DS_ID:19838 EP_NO: N/A Repair Type: Urgent Crossing Status: Found UCIP Comments: Pipe blocked by silt on LS toe. Flapgate rusty and does not operate correctly. FIELD_STRUCT_DESC: 36-inch CM stormdrain pipe through levee, 13.4 feet below crown. Flap gate on the waterward end. (USACE-1967). This entry matches the Drainage or Irrigation Structure referenced in O&M manual (HLM 3.06). FS Date: 4/16/2014

Pipe, headwall, and flapgate on WS toe.

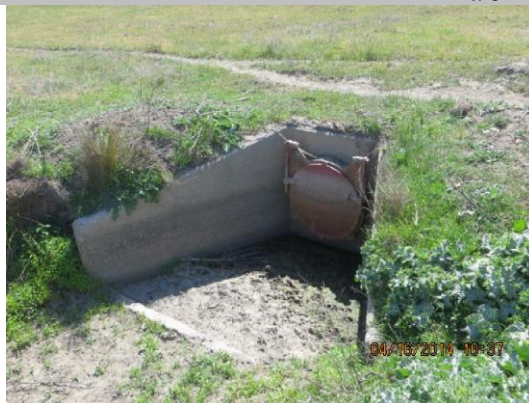
Photo 2 of 2 : UCIP_SP_2016_42853_61113.jpg

LM Start	3.06	Rating **	U	Issue No.	21 (cont)	
LM End	3.06	Issue Type +	En	Location *	LS	
Category	Supplemental			GPS Latitude/Longitude		
				Start	End	
Item	DWR UCIP Field Study			37.250864 °	37.250864 °	
				-120.728151 °	-120.728151 °	
DWR ID						
Comment Code						
Inspector Comment						
FS_ID:42853 DS_ID:19838 EP_NO: N/A Repair Type: Urgent Crossing Status: Found UCIP Comments: Pipe blocked by silt on LS toe. Flapgate rusty and does not operate correctly. FIELD_STRUCT_DESC: 36-inch CM stormdrain pipe through levee, 13.4 feet below crown. Flap gate on the waterward end. (USACE-1967). This entry matches the Drainage or Irrigation Structure referenced in O&M manual (HLM 3.06). FS Date: 4/16/2014

Pipe, headwall, and flapgate on WS toe.

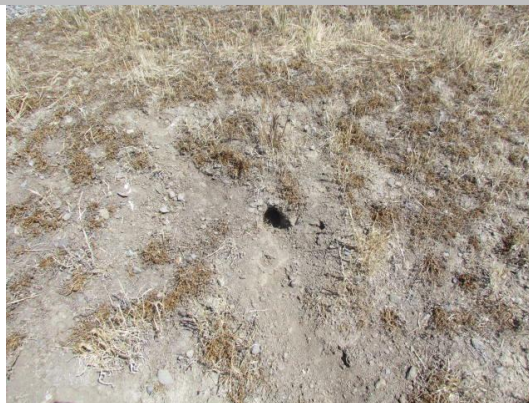
Photo 1 of 1 : SP_2016_NA0010_126_3_20160512_00001.jpg

LM Start	3.40	Rating **	M	Issue No.	3
LM End	3.54	Issue Type +	Ma	Location *	LS
Category	Earthen Levee			GPS Latitude/Longitude	
				Start	End
Item	Animal Control			37.253052 °	37.253600 °
				-120.722647 °	-120.720198 °
DWR ID	DWR_NA0010_08_s_2012_3				
Comment Code					
A3 : No rodents visible, but rodent burrows visible; need to backfill and compact or grout burrows.					
Inspector Comment					
Noted several rodent holes on landward slope within this reach.

Looking at typical view of rodent holes on landward slope.

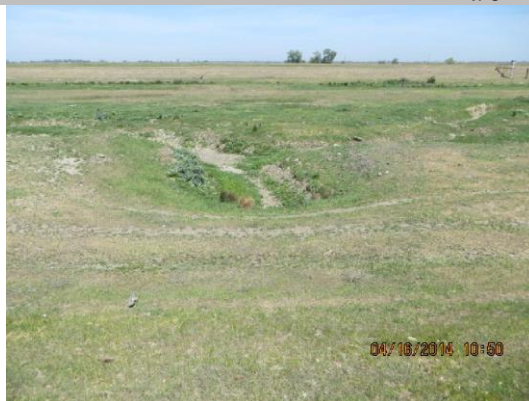
Photo 1 of 2 : UCIP_SP_2016_39513_61134.jpg

LM Start	3.43	Rating **	M	Issue No.	20
LM End	3.43	Issue Type +	En	Location *	LS
Category	Supplemental			GPS Latitude/Longitude	
				Start	End
Item	DWR UCIP Field Study			37.253151 °	37.253151 °
				-120.722182 °	-120.722182 °
DWR ID					
Comment Code					
Inspector Comment					
FS_ID:39513 DS_ID:19840 EP_NO: N/A Repair Type: Non-Urgent Crossing Status: Found UCIP Comments: No access available on landward side. Need to confirm status of crossing. FIELD_STRUCT_DESC: 24-inch CM stormdrain pipe through levee, 13.0 feet below crown. Flap gate on the waterward end. Concrete headwall on both ends. (USACE-1967). This entry matches the Drainage or Irrigation Structure referenced in O&M manual (HLM 3.43). FS Date: 4/16/2014

Pipe, headwall, and flapgate on WS toe.

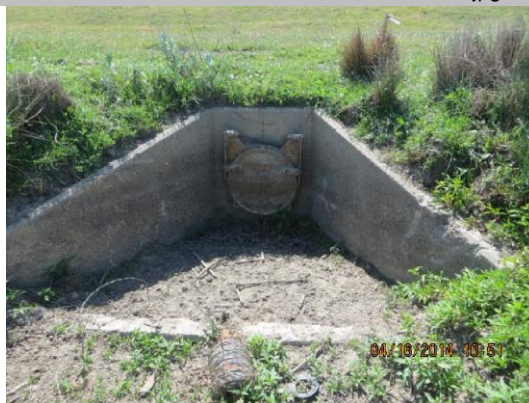
Photo 2 of 2 : UCIP_SP_2016_39513_61133.jpg

Pipe, headwall, and flapgate on WS toe.

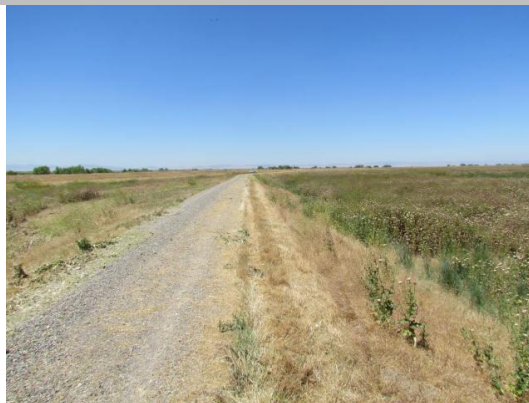
Photo 1 of 1 : SP_2016_NA0010_127_3_20160523_00008.jpg

LM Start	0.00	Rating **	M	Issue No.	3
LM End	0.87	Issue Type +	Ma	Location *	LS
Category	Earthen Levee			GPS Latitude/Longitude	
				Start	End
Item	Vegetation			37.220261 °	37.220065 °
				-120.713028 °	-120.698350 °
DWR ID	DWR_NA0010_09_s_2016_3				
Comment Code					
V1 : Control annual grass and weeds on the levee slopes and easements.					
Inspector Comment

Looking west at typical view of waterward slope.

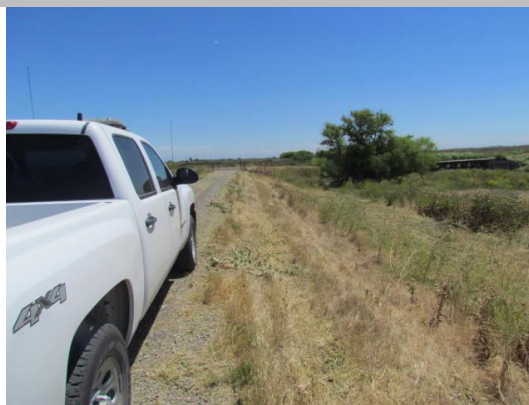
Photo 1 of 1 : SP_2016_NA0010_127_4_20160523_00007.jpg

LM Start	0.00	Rating **	M	Issue No.	4
LM End	0.87	Issue Type +	Ma	Location *	WS
Category	Earthen Levee			GPS Latitude/Longitude	
				Start	End
Item	Vegetation			37.220262 °	37.220065 °
				-120.713028 °	-120.698350 °
DWR ID	DWR_NA0010_09_s_2016_4				
Comment Code					
V1 : Control annual grass and weeds on the levee slopes and easements.					
Inspector Comment

Looking east at typical view of waterward slope.

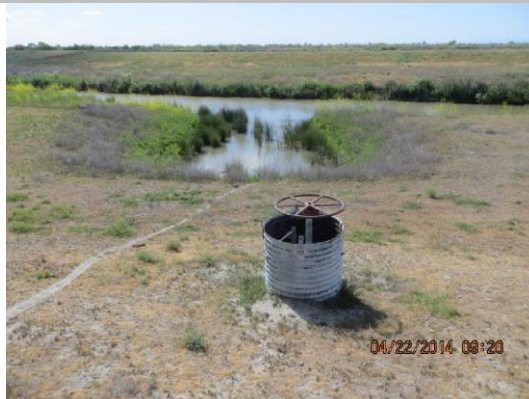
Photo 1 of 2 : UCIP_SP_2016_39888_62119.jpg

LM Start	0.47	Rating **	M	Issue No.	7
LM End	0.47	Issue Type +	En	Location *	WS
Category	Supplemental			GPS Latitude/Longitude	
				Start	End
Item	DWR UCIP Field Study			37.220416 °	37.220416 °
				-120.705248 °	-120.705248 °
DWR ID					
Comment Code					
Inspector Comment					
FS_ID:39888					
DS_ID:19841					
EP_NO: N/A					
Repair Type: Non-Urgent					
Crossing Status: Found					
UCIP Comments: Concrete headwalls on landward and waterward under water. Need photo to confirm condition of concrete headwalls, pipe, and gate on both toes.					
FIELD_STRUCT_DESC: 24-inch C.M. stormdrain pipe through the levee, 18.7-feet below the crown. Slide gate inside 36-inch C.M. pipe riser on the waterward slope. Concrete "U" headwalls on both ends. (USACE-1967). This entry matches the Drainage or Irrigation Structure referenced in O&M manual (HLM 0.47).					
FS Date: 4/22/2014

Slide gate in CMP riser on WS slope with outlet visible in background.

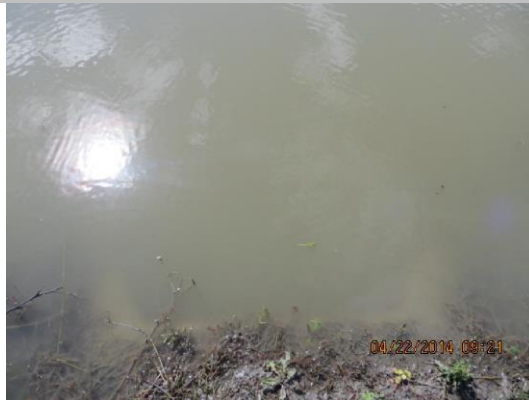
Photo 2 of 2 : UCIP_SP_2016_39888_62117.jpg

Concrete headwall visible under water on WS toe.

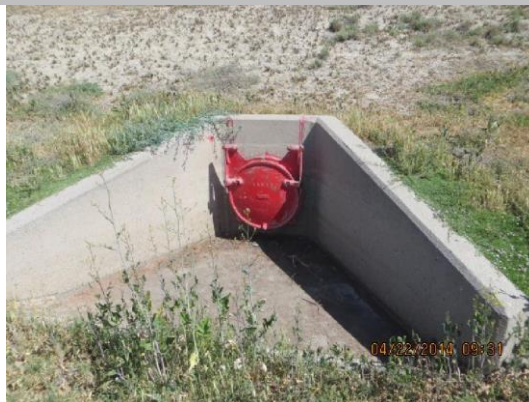
Photo 2 of 2 : UCIP_SP_2016_39515_62132.jpg

Headwall, flapgate, and pipe on WS toe.

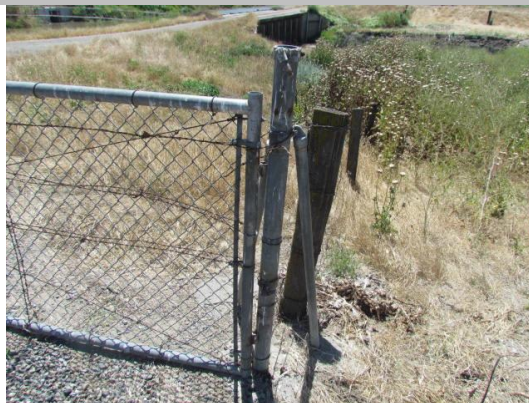
Photo 1 of 1 : SP_2016_NA0010_127_5_20160523_00009.jpg

LM Start	0.87	Rating **	U	Issue No.	5
LM End	0.87	Issue Type +	Ma	Location *	CR
Category	Earthen Levee			GPS Latitude/Longitude	
				Start	End
Item	Repair Gates			37.220065 °	37.220065 °
				-120.698350 °	-120.698350 °
DWR ID	DWR_NA0010_09_s _ 2016_5				
Comment Code					
Inspector Comment					
Gate hinges broken. Safety hazard.

Looking at missing hingers on fence post.

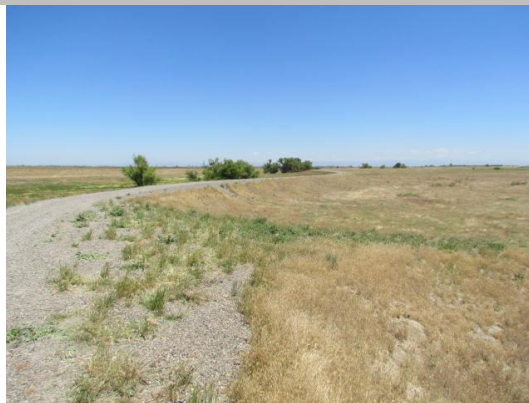
Photo 1 of 1 : SP_2016_NA0010_128_3_20160523_00005.jpg

LM Start	0.00	Rating **	M	Issue No.	3
LM End	0.79	Issue Type +	Ma	Location *	LS
Category	Earthen Levee			GPS Latitude/Longitude	
				Start	End
Item	Vegetation			37.217903 °	37.219366 °
				-120.711439 °	-120.698019 °
DWR ID	DWR_NA0010_10_s_2016_3				
Comment Code					
V1 : Control annual grass and weeds on the levee slopes and easements.					
Inspector Comment

Looking at typical of landward slope.

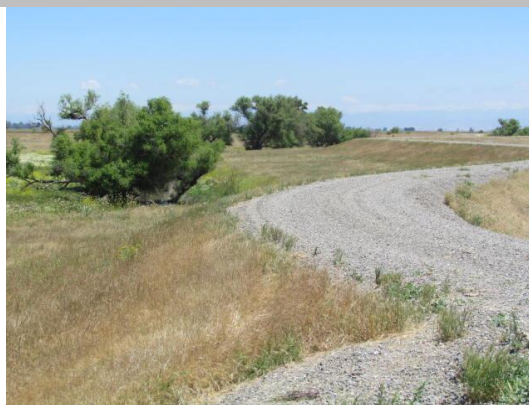
Photo 1 of 1 : SP_2016_NA0010_128_4_20160523_00006.jpg

LM Start	0.00	Rating **	M	Issue No.	4
LM End	0.79	Issue Type +	Ma	Location *	WS
Category	Earthen Levee			GPS Latitude/Longitude	
				Start	End
Item	Vegetation			37.217903 °	37.219366 °
				-120.711439 °	-120.698018 °
DWR ID	DWR_NA0010_10_s_2016_4				
Comment Code					
V1 : Control annual grass and weeds on the levee slopes and easements.					
Inspector Comment

Looking at typical view of waterward slope.

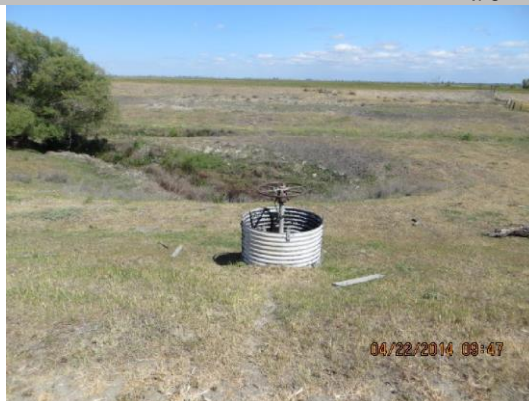
Photo 1 of 2 : UCIP_SP_2016_39516_62144.jpg

LM Start	0.30	Rating **	M	Issue No.	5
LM End	0.30	Issue Type +	En	Location *	WS
Category	Supplemental			GPS Latitude/Longitude	
				Start	End
Item	DWR UCIP Field Study			37.219116 °	37.219116 °
				-120.706652 °	-120.706652 °
DWR ID					
Comment Code					
Inspector Comment					
FS_ID:39516 DS_ID:19845 EP_NO: N/A Repair Type: Non-Urgent Crossing Status: Found UCIP Comments: Inlet blocked at LS toe by wooden gate. Need to contact owner to determine status. FIELD_STRUCT_DESC: 36-inch CM stormdrain pipe through levee, 19.6-feet below crown. Slide gate in 48-inch CM pipe riser on the waterward slope. Concrete "U" headwalls on both ends. (USACE-1967). This entry matches the Drainage or Irrigation Structure referenced in O&M manual (HLM 0.31). FS Date: 4/22/2014

Headwall and pipe visible on LS toe. Slide gate inside 48-inch CMP riser on WS slope.

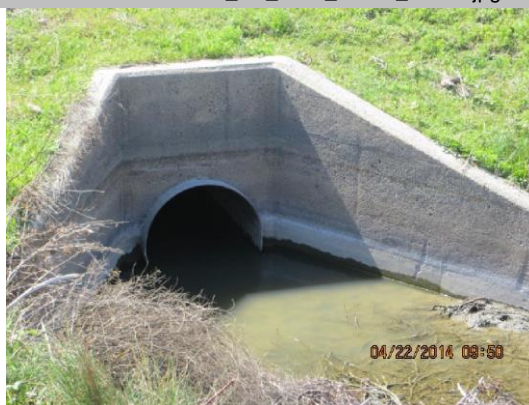
Photo 2 of 2 : UCIP_SP_2016_39516_62146.jpg

Headwall and pipe on WS toe.

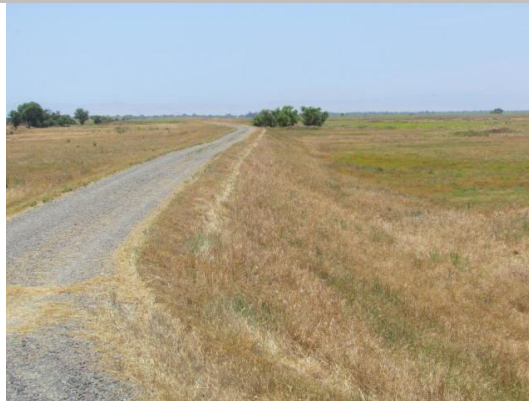
Photo 1 of 1 : SP_2016_NA0010_129_9_20160523_00023.jpg

LM Start	0.00	Rating **	A	Issue No.	9
LM End	3.31	Issue Type +	Ma	Location *	LS
Category	Earthen Levee			GPS Latitude/Longitude	
				Start	End
Item	Vegetation			37.202748 °	37.202310 °
				-120.755210 °	-120.695281 °
DWR ID	DWR_NA0010_11_s _ 2016_9				
Comment Code					
V1 : Control annual grass and weeds on the levee slopes and easements.					
Inspector Comment

Looking at typical view of landward slope.

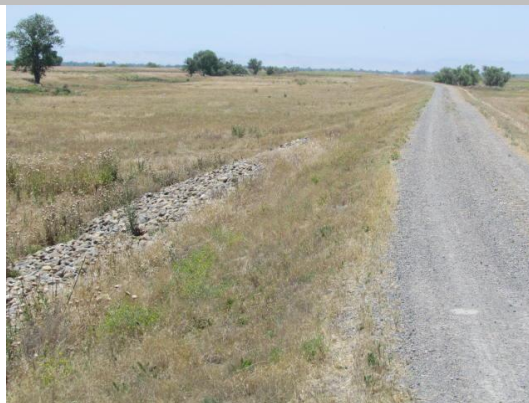
Photo 1 of 1 : SP_2016_NA0010_129_10_20160523_00022.jpg

LM Start	0.00	Rating **	A	Issue No.	10
LM End	3.31	Issue Type +	Ma	Location *	WS
Category	Earthen Levee			GPS Latitude/Longitude	
				Start	End
Item	Vegetation			37.202748 °	37.202310 °
				-120.755210 °	-120.695281 °
DWR ID	DWR_NA0010_11_s _ 2016_10				
Comment Code					
V1 : Control annual grass and weeds on the levee slopes and easements.					
Inspector Comment

Looking east at typical view of waterward slope.

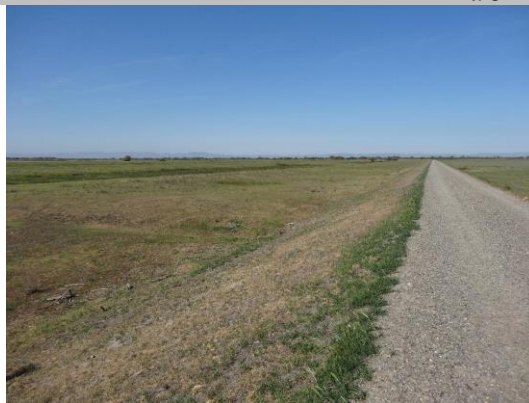
Photo 1 of 2 : UCIP_SP_2016_39518_61997.jpg

LM Start	0.65	Rating **	M	Issue No.	12
LM End	0.65	Issue Type +	En	Location *	WS
Category	Supplemental			GPS Latitude/Longitude	
				Start	End
Item	DWR UCIP Field Study			37.202751 °	37.202751 °
				-120.743474 °	-120.743474 °
DWR ID					
Comment Code					
Inspector Comment					
FS_ID:39518					
DS_ID:19847					
EP_NO: N/A					
Repair Type: Non-Urgent					
Crossing Status: Found					
UCIP Comments: Need to contact owner. Recommend clearing sediment deposit inside pipe.					
FIELD_STRUCT_DESC: 24-inch C.M. pipe through the levee, 10.0 feet below the crown. Flap gate on the waterward end. (USACE-1967). This entry matches the Drainage or Irrigation Structure referenced in O&M manual (HLM 0.65).					
FS Date: 4/18/2014

View of waterward side.

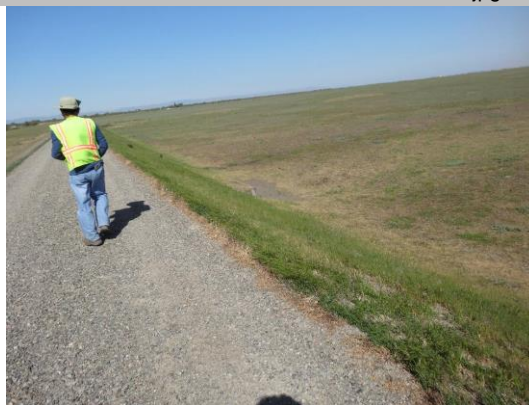
Photo 2 of 2 : UCIP_SP_2016_39518_61996.jpg

View of landward side.

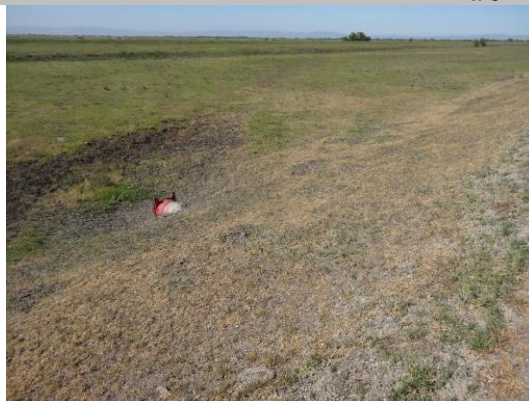
Photo 1 of 2 : UCIP_SP_2016_39520_62008.jpg

LM Start	1.13	Rating **	M	Issue No.	14
LM End	1.13	Issue Type +	En	Location *	WS
Category	Supplemental			GPS Latitude/Longitude	
				Start	End
Item	DWR UCIP Field Study			37.202748 °	37.202748 °
				-120.734796 °	-120.734796 °
DWR ID					
Comment Code					
Inspector Comment					
FS_ID:39520 DS_ID:19849 EP_NO: N/A Repair Type: Non-Urgent Crossing Status: Found UCIP Comments: Need to contact owner. Recommend clearing sediment deposit inside pipe. FIELD_STRUCT_DESC: 24-inch C.M. pipe through the levee, 9.0 feet below the crown. Flap gate on the waterward end. (USACE-1967). This entry matches the Drainage or Irrigation Structure referenced in O&M manual (HLM 1.13). FS Date: 4/18/2014

View of waterward side--flap gate visible at levee toe.

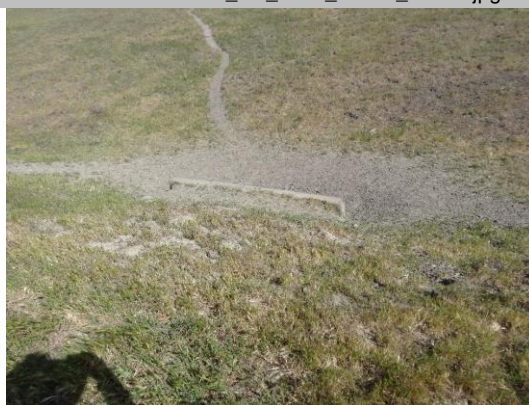
Photo 2 of 2 : UCIP_SP_2016_39520_62007.jpg

View of landward side.

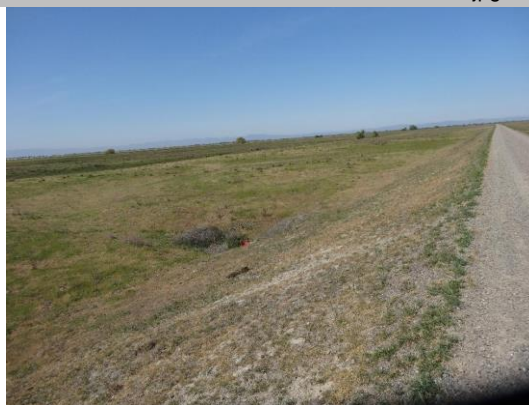
Photo 1 of 2 : UCIP_SP_2016_39522_62024.jpg

LM Start	1.98	Rating **	M	Issue No.	16
LM End	1.98	Issue Type +	En	Location *	LS
Category	Supplemental			GPS Latitude/Longitude	
				Start	End
Item	DWR UCIP Field Study			37.202740 °	37.202740 °
				-120.719247 °	-120.719247 °
DWR ID					
Comment Code					
Inspector Comment					
FS_ID:39522					
DS_ID:19851					
EP_NO: N/A					
Repair Type: Non-Urgent					
Crossing Status: Found					
UCIP Comments: Need to contact owner. Recommend clearing sediment deposit inside pipe.					
FIELD_STRUCT_DESC: 24-inch C.M. pipe through the levee, 12.8 feet below the crown. Flap gate on the waterward end. (USACE-1967). This entry matches the Drainage or Irrigation Structure referenced in O&M manual (HLM 1.99).					
FS Date: 4/18/2014

View of waterward side.

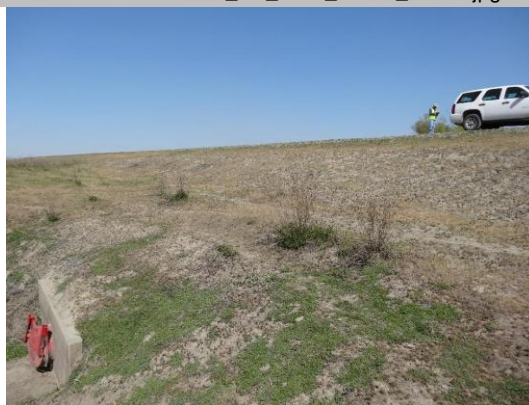
Photo 1 of 2 : UCIP_SP_2016_39523_62028.jpg

LM Start	3.04	Rating **	M	Issue No.	17
LM End	3.04	Issue Type +	En	Location *	LS
Category	Supplemental			GPS Latitude/Longitude	
				Start	End
Item	DWR UCIP Field Study			37.202494 °	37.202494 °
				-120.700153 °	-120.700153 °
DWR ID					
Comment Code					
Inspector Comment					
FS_ID:39523 DS_ID:19852 EP_NO: N/A Repair Type: Non-Urgent Crossing Status: Found UCIP Comments: Need to contact owner. Recommend clearing sediment deposit inside pipe. FIELD_STRUCT_DESC: 24-inch C.M. pipe through the levee, 15.0 feet below the crown. Flap gate on the waterward end. (USACE-1967). This entry matches the Drainage or Irrigation Structure referenced in O&M manual (HLM 3.04). FS Date: 4/18/2014

Overview of waterward side--flap gate, concrete headwall and apron visible on levee toe.

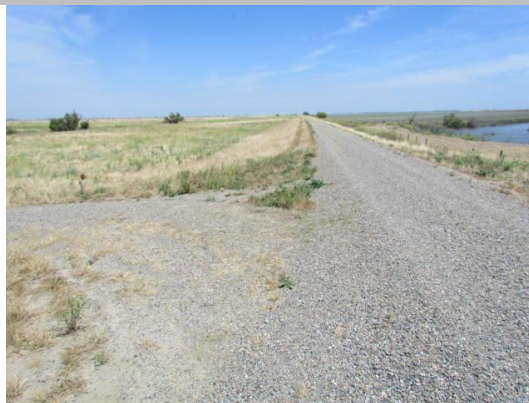
Photo 1 of 1 : SP_2016_NA0010_130_10_20160523_00022.jpg

LM Start	0.00	Rating **	A	Issue No.	10
LM End	3.33	Issue Type +	Ma	Location *	WS
Category	Earthen Levee			GPS Latitude/Longitude	
				Start	End
Item	Vegetation			37.200939 °	37.200973 °
				-120.755179 °	-120.694883 °
DWR ID	DWR_NA0010_12_s_2016_10				
Comment Code					
V1 : Control annual grass and weeds on the levee slopes and easements.					
Inspector Comment

Looking at typical view of waterward slope.

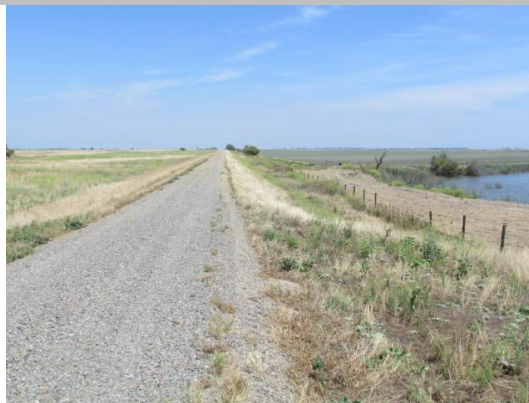
Photo 1 of 1 : SP_2016_NA0010_130_11_20160523_00023.jpg

LM Start	0.00	Rating **	A	Issue No.	11
LM End	3.33	Issue Type +	Ma	Location *	LS
Category	Earthen Levee			GPS Latitude/Longitude	
				Start	End
Item	Vegetation			37.200939 °	37.200973 °
				-120.755178 °	-120.694883 °
DWR ID	DWR_NA0010_12_s_2016_11				
Comment Code					
V1 : Control annual grass and weeds on the levee slopes and easements.					
Inspector Comment

Looking at typical view of landward slope.

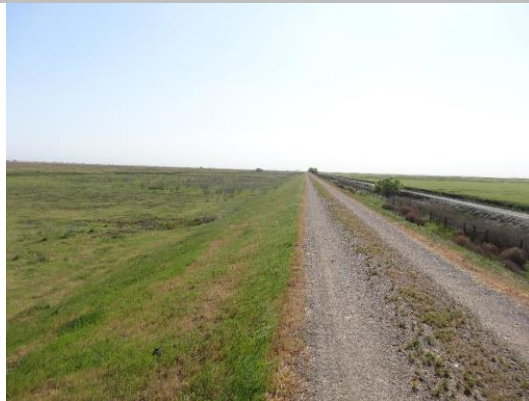
Photo 1 of 2 : UCIP_SP_2016_36704_66647.jpg

LM Start	0.40	Rating **	M	Issue No.	13
LM End	0.40	Issue Type +	En	Location *	LS
Category	Supplemental			GPS Latitude/Longitude	
				Start	End
Item	DWR UCIP Field Study			37.200934 °	37.200934 °
				-120.747996 °	-120.747996 °
DWR ID					
Comment Code					
Inspector Comment					
FS_ID:36704 DS_ID:19855 EP_NO: N/A Repair Type: Non-Urgent Crossing Status: Found UCIP Comments: Need to contact owner. Dense vegetation limits the inspector's visibility to identify signs of pipe failure (leaks) along the waterward slope. Recommend removing vegetation along pipe alignment to conduct proper inspection of structure. FIELD_STRUCT_DESC: 24-inch CM pipe through levee, 10.5 feet below crown. Flap gate on the waterward end. (USACE-1967). This entry matches the Drainage or Irrigation Structure referenced in O&M manual (HLM 0.39). FS Date: 4/18/2014

View of waterward side.

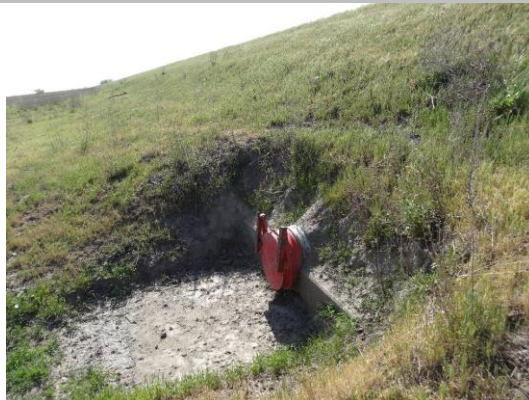
Photo 2 of 2 : UCIP_SP_2016_36704_66649.jpg

Concrete headwall and flap gate visible on waterward side.

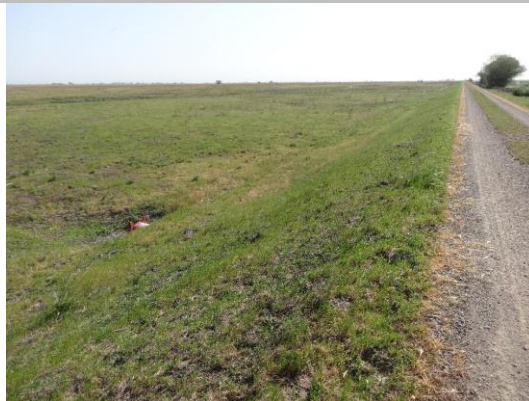
Photo 1 of 2 : UCIP_SP_2016_39889_62048.jpg

LM Start	1.06	Rating **	M	Issue No.	16
LM End	1.06	Issue Type +	En	Location *	LS
Category	Supplemental			GPS Latitude/Longitude	
				Start	End
Item	DWR UCIP Field Study			37.200922 °	37.200922 °
				-120.736012 °	-120.736012 °
DWR ID					
Comment Code					
Inspector Comment					
FS_ID:39889					
DS_ID:19856					
EP_NO: N/A					
Repair Type: Non-Urgent					
Crossing Status: Found					
UCIP Comments: Need to contact owner. Recommend clearing sediment deposit inside pipe.					
FIELD_STRUCT_DESC: 24-inch CM pipe through levee, 10.5 feet below crown. Flap gate on the waterward end. (USACE-1967). This entry matches the Drainage or Irrigation Structure referenced in O&M manual (HLM 1.06).					
FS Date: 4/18/2014

View of waterward side.

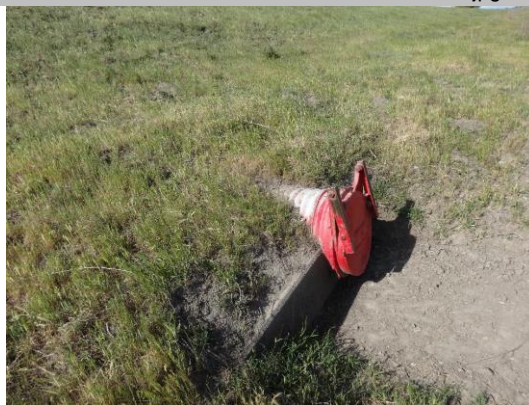
Photo 2 of 2 : UCIP_SP_2016_39889_62049.jpg

Concrete headwall and flap gate visible on waterward side.

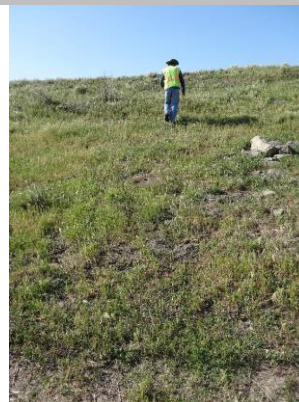
Photo 2 of 2 : UCIP_SP_2016_36705_66652.jpg

View of waterward slope.

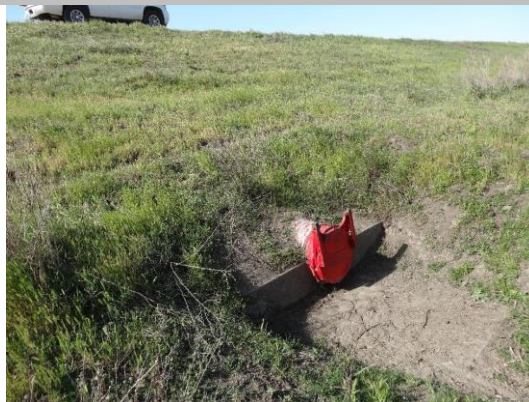
Photo 2 of 2 : UCIP_SP_2016_34126_62061.jpg

Concrete headwall and flap gate visible on waterward side.

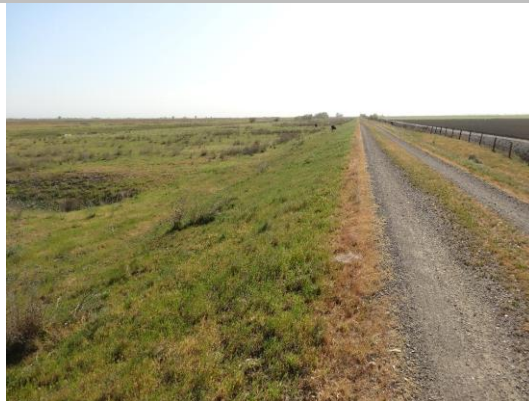
Photo 1 of 2 : UCIP_SP_2016_39506_62064.jpg

LM Start	2.16	Rating **	M	Issue No.	15
LM End	2.16	Issue Type +	En	Location *	LS
Category	Supplemental			GPS Latitude/Longitude	
				Start	End
Item	DWR UCIP Field Study			37.200908 °	37.200908 °
				-120.716118 °	-120.716118 °
DWR ID					
Comment Code					
Inspector Comment					
FS_ID:39506					
DS_ID:19859					
EP_NO: N/A					
Repair Type: Non-Urgent					
Crossing Status: Found					
UCIP Comments: Need to contact owner. Recommend clearing vegetation from landward side--headwall blocked.					
FIELD_STRUCT_DESC: 24-inch CM pipe through levee, 14.4 feet below crown. Flap gate on the waterward end. (USACE-1967). This entry matches the Drainage or Irrigation Structure referenced in O&M manual (HLM 2.16).					
FS Date: 4/18/2014

View of waterward side.

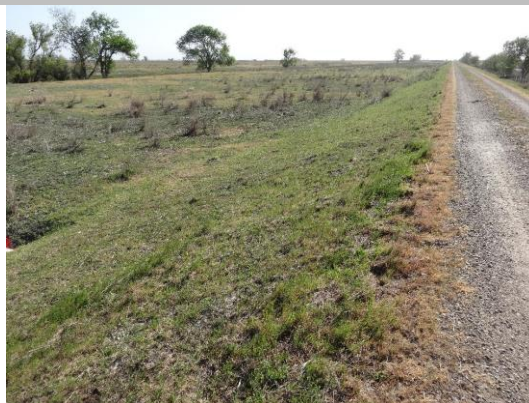
Photo 1 of 2 : UCIP_SP_2016_39890_62069.jpg

LM Start	2.70	Rating **	M	Issue No.	17
LM End	2.70	Issue Type +	En	Location *	LS
Category	Supplemental			GPS Latitude/Longitude	
				Start	End
Item	DWR UCIP Field Study			37.200906 °	37.200906 °
				-120.706316 °	-120.706316 °
DWR ID					
Comment Code					
Inspector Comment					
FS_ID:39890 DS_ID:19860 EP_NO: N/A Repair Type: Non-Urgent Crossing Status: Found UCIP Comments: Need to contact owner. Recommend clearing sediment deposit inside pipe. FIELD_STRUCT_DESC: 24-inch CM pipe through levee, 10.7 feet below crown. Flap gate on the waterward end. (USACE-1967). This entry matches the Drainage or Irrigation Structure referenced in O&M manual (HLM 2.70). FS Date: 4/18/2014

View of waterward side.

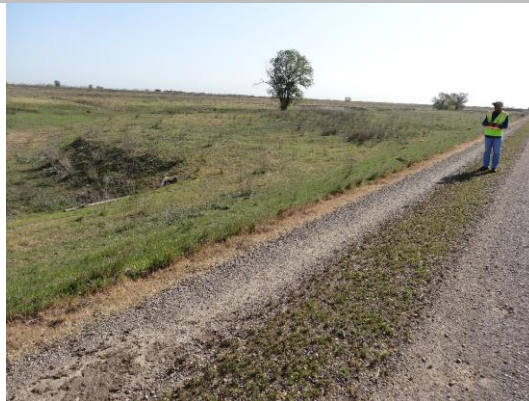
Photo 1 of 2 : UCIP_SP_2016_46786_62073.jpg

FS_ID:46786
DS_ID:19861
EP_NO: N/A
Repair Type: Non-Urgent
Crossing Status: Found
UCIP Comments: 11-09-2015 DWR Inspection section confirmed issue has been addressed. Need to coordinate with LMA to determine additional details for extent of repair. 10-18-2014 Soil missing behind concrete headwall on waterward side. Unable to determine if missing soil is due to sink holes, rodent activity, or due to erosion. Headwall appears to be leaning slightly forward. Reason why this crossing was labelled urgent was due to the uncertainty of damage to concrete headwall and reason for soil missing behind concrete. Need to coordinate with LMA to determine more information about repair at this location.
FIELD_STRUCT_DESC: 24-inch CM pipe through levee, 2 feet below levee crown. Flap gate on the waterward end. (USACE-1967). This entry matches the Drainage or Irrigation Structure referenced in O&M manual (HLM 3.00).

View of waterward side.

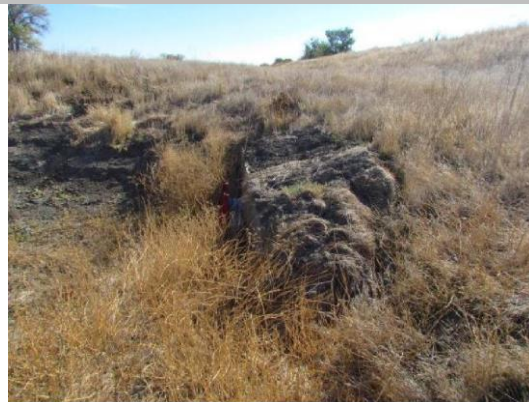
Photo 2 of 2 : UCIP_SP_2016_46786_74729.jpg

Repair to headwall located on waterward side has been addressed.

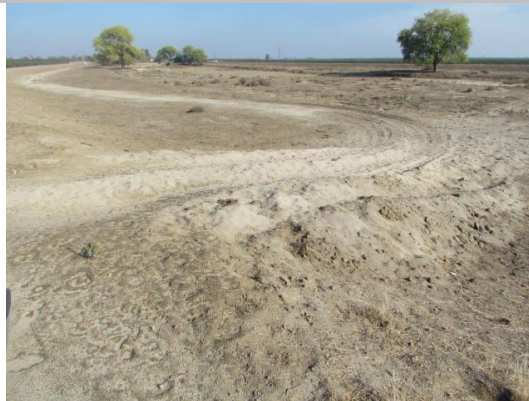
Photo 1 of 3 : SP_2016_NA0010_131_5_20160512_00001.jpg

Looking at unauthorized ramp on waterward slope. (Fall 2014)

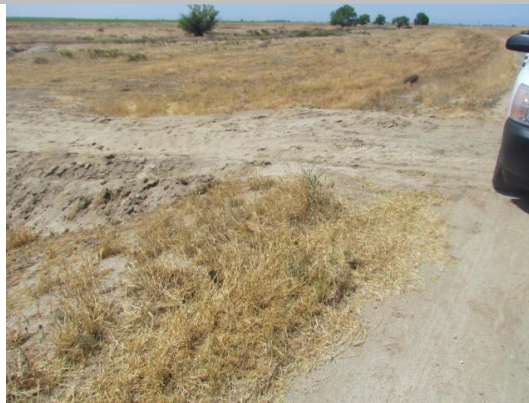
Photo 2 of 3 : SP_2016_NA0010_131_5_20160512_00002.jpg

Looking west at unauthorized ramp on waterward slope.

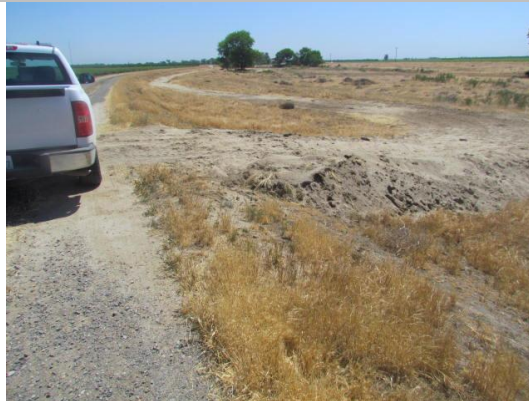
Photo 3 of 3 : SP_2016_NA0010_131_5_20160512_00003.jpg

Looking east at unauthorized ramp on waterward slope.

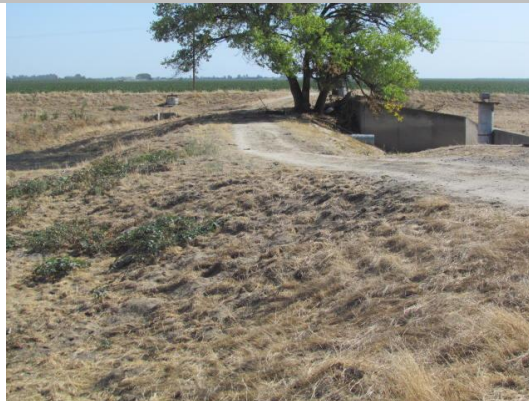
Photo 1 of 5 : SP_2016_NA0010_131_6_20160512_00004.jpg

Looking south at sand dam on upstream side of structure.

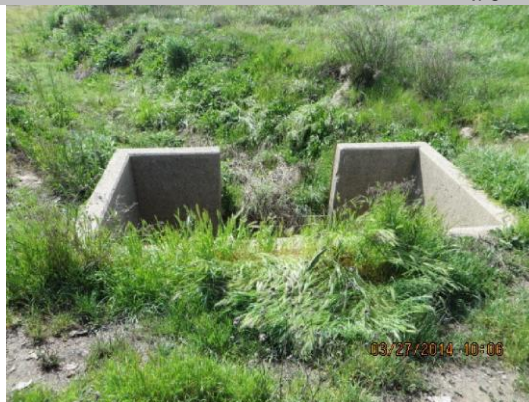
LM Start	7.18	Rating **	M	Issue No.	1253
LM End	7.18	Issue Type +	En	Location *	LS
Category	Supplemental			GPS Latitude/Longitude	
				Start	End
Item	DWR UCIP Field Study			37.300055 °	37.300055 °
				-120.882939 °	-120.882939 °
DWR ID

LM Start	7.18	Rating **	M	Issue No.	1253 (cont)
LM End	7.18	Issue Type +	En	Location *	LS

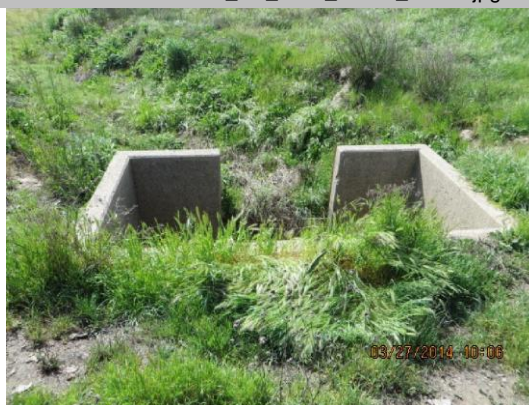
Waterway	Bank	Unit Miles	Inspection Start/End	Inspector
Unit No. 01 San Joaquin River	Right	22.52	05/16/2016 05/19/2016	Richard Willoughby

Comment Code					
Inspector Comment					
FS_ID:39160 DS_ID:19617 EP_NO: 4425 Repair Type: Non-Urgent Crossing Status: Found UCIP Comments: Recommend contacting owner to determine status of crossing. No pump was found on waterwaard side (riverbank). If crossing is no longer used need to coordinate with CVFPB for proper abandonment. FIELD_STRUCT_DESC: 24-inch steel irrigation pipe through the levee, 13.6 feet below the crown. Pipe encased in 6-inches of concrete through levee. 5'X7' Concrete distribution box on the waterward side. 20-inch concrete standpipe at LS toe. Pump on the riverbank, accessible by walkway platform (Pump not found). Concrete cutoff walls around pipe in line with levee shoulders. Pipe extends to 36-inch concrete pipes on both sides of levee. (Permit No. 4425-1965) FS Date: 4/8/2014

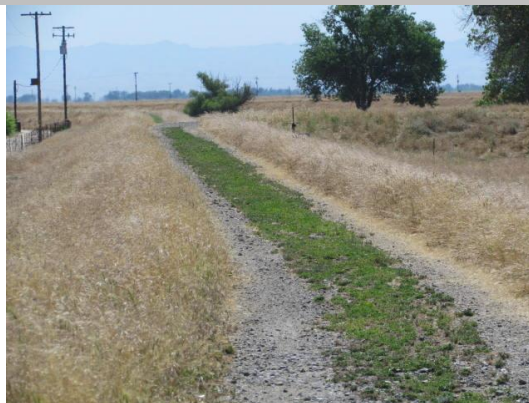
Pipe and flapgate visible on WS toe.

**Flood Control Project Maintenance
Levee Inspections**

LM Start	0.00	Rating **	M	Issue No.	2
LM End	1.26	Issue Type +	Ma	Location *	CR
Category	Earthen Levee			GPS Latitude/Longitude	
				Start	End
Item	Crown Surface / Depressions / Rutting			37.032379 °	37.045404 °
				-120.441265 °	-120.427749 °
DWR ID	DWR_NA0010_14_f_2012_2				
Comment Code					
C3 : Add appropriate gravel or road base. Grade and compact.					
Inspector Comment					
Control vegetation on levee crown.

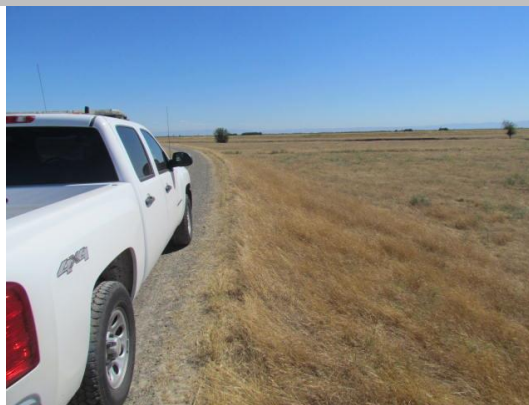
Photo 1 of 2 : UCIP_SP_2016_39243_60842.jpg

Flapgate and headwall at WS toe. Heavy vegetation on slopes.

LM Start	0.00	Rating **	M	Issue No.	4
LM End	1.26	Issue Type +	Ma	Location *	WS
Category	Earthen Levee			GPS Latitude/Longitude	
				Start	End
Item	Vegetation			37.032394 °	37.045430 °
				-120.441279 °	-120.427711 °
DWR ID	DWR_NA0010_14_s_2016_4				
Comment Code					
V1 : Control annual grass and weeds on the levee slopes and easements.					
Inspector Comment

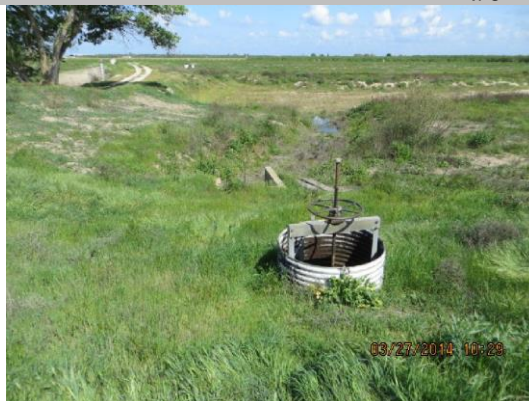
Photo 1 of 2 : UCIP_SP_2016_39244_60844.jpg

Pipe, Headwall, and flapgate at WS toe.

FS_ID:39526
DS_ID:19909
EP_NO: N/A
Repair Type: Non-Urgent
Crossing Status: Found
UCIP Comments: Lid should be installed on CMP riser on WS slope, could be a safety hazard. Also dense vegetation limits the inspector's visibility to identify signs of pipe failure (leaks) along the slope. Recommend removing vegetation along pipe alignment to conduct proper inspection of structure.
FIELD_STRUCT_DESC: 36-inch CM pipe through levee, 10-feet below crown. Slide gate inside 48-inch CM pipe riser in waterward slope. Concrete distribution box (6'X7') at toe of waterward slope. Slots for wooden flashboard on waterward side of box. 7'X9' Concrete distribution box on the landward side 20-feet from toe. (USACE-1967). This entry matches the Drainage or Irrigation Structure referenced in O&M manual (HLM 1.15).
FS Date: 3/27/2014

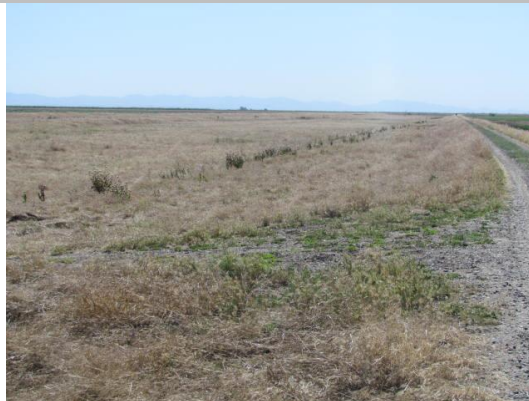
Levee Inspection Report By Mile - Spring 2016

LM Start	0.00	Rating **	M	Issue No.	4
LM End	1.99	Issue Type +	Ma	Location *	WS
Category	Earthen Levee			GPS Latitude/Longitude	
				Start	End
Item	Vegetation			36.996606 °	36.996587 °
				-120.410410 °	-120.374500 °
DWR ID	DWR_NA0010_15_s _ 2016_4				
Comment Code					
V1 : Control annual grass and weeds on the levee slopes and easements.					
Inspector Comment

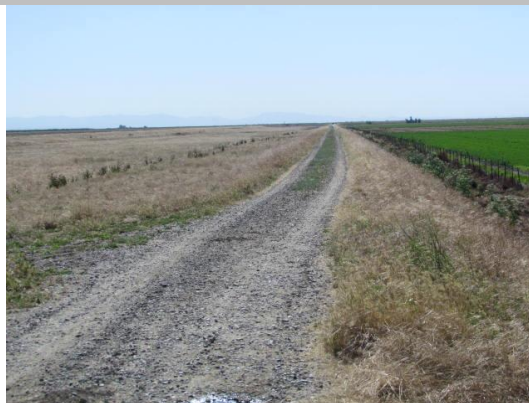
Waterway	Bank	Unit Miles	Inspection Start/End	Inspector
Unit No. 01 San Joaquin River	Right	22.52	05/16/2016 05/19/2016	Richard Willoughby

Comment Code

LM Start	0.00	Rating **	M	Issue No.	3
LM End	1.99	Issue Type +	Ma	Location *	LS
Category	Earthen Levee			GPS Latitude/Longitude	
				Start	End
Item	Vegetation			36.996606 °	36.996587 °
				-120.410409 °	-120.374500 °
DWR ID	DWR_NA0010_15_s _ 2016_3				
Comment Code					
V1 : Control annual grass and weeds on the levee slopes and easements.					
Inspector Comment
