**Flood Control Project Maintenance
Levee Inspections****LMA District Cover Sheet****Spring 2016 Levee Inspection Results****Lower San Joaquin Levee District**

Spring 2016 Levee Inspection Results

Lower San Joaquin Levee District

Waterway			Bank	Unit Miles
Unit No. 01 San Joaquin River			Right	22.52
	Spring (March - May)	Summer (June - August)	(September - November) Fall	Winter (December - February)
Unit Maintenance Rating (Fall Only)				
Date of Inspection	5/16/2016 - 5/19/2016			
DWR Inspector	Richard Willoughby			
Accompanied By

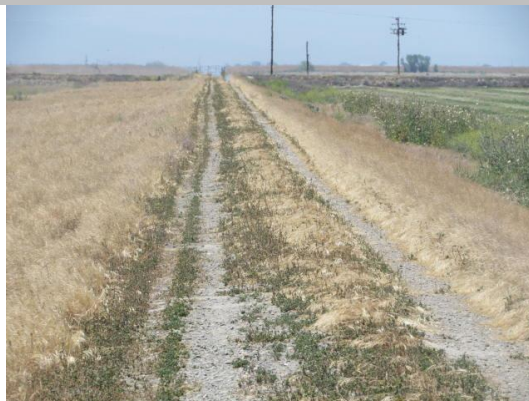
**Flood Control Project Maintenance
Levee Inspections**

Lower San Joaquin Levee District

LM Start	0.01	Rating **	M	Issue No.	11 (cont)	
LM End	1.99	Issue Type +	Ma	Location *	CR	
Category	Earthen Levee			GPS Latitude/Longitude		
				Start		End
Item	Crown Surface / Depressions / Rutting			36.996547 °		36.996587 °
				-120.410220 °		-120.374503 °
DWR ID	DWR_NA0010_15_s _ 2012_11					
Comment Code						
C1 : Add appropriate material and re-grade the levee to bring the crown above the design elevation.						
Inspector Comment						
Control vegetation on levee crown.

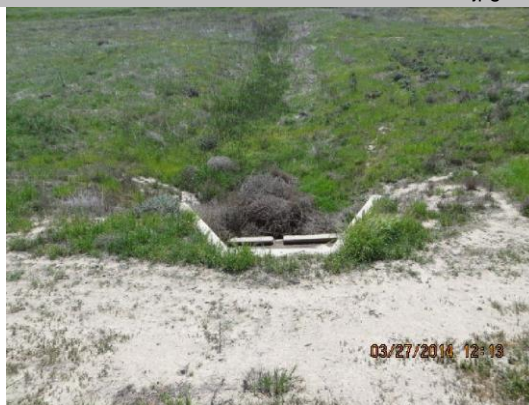
Comment Code					
Inspector Comment					
FS_ID:39527 DS_ID:19912 EP_NO: N/A Repair Type: Non-Urgent Crossing Status: Found UCIP Comments: Dense vegetation limits the inspector's visibility to identify signs of pipe failure (leaks) along the landward slope. Recommend removing vegetation along pipe alignment to conduct proper inspection of structure. FIELD_STRUCT_DESC: 30-inch square R.C.B.C. through the levee, 8.5 feet below the crown. Concrete "U" headwall on the waterward end. Flap gate on the waterward end. Concrete headwall on the landward end. (USACE-1967). This entry matches the Drainage or Irrigation Structure referenced in O&M manual (HLM 1.01). FS Date: 3/27/2014

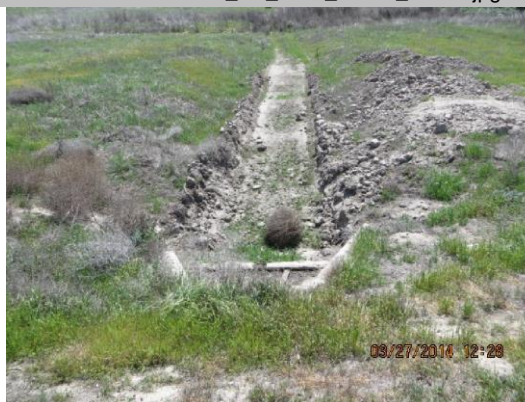
LM Start	1.53	Rating **	M	Issue No.	12
LM End	1.53	Issue Type +	En	Location *	CR
Category	Supplemental			GPS Latitude/Longitude	
				Start	End
Item	DWR UCIP Field Study			36.996582 °	36.996582 °
				-120.382757 °	-120.382757 °
DWR ID					
Comment Code					
Inspector Comment					
FS_ID:32840 DS_ID:19913 EP_NO: N/A Repair Type: Non-Urgent Crossing Status: Found UCIP Comments: Excessive vegetation at inlet on LS toe. FIELD_STRUCT_DESC: 30-inch square R.C.B.C. stormdrain through the levee, 8.9 feet below the crown. Concrete "U" headwall on the waterward end. Flap gate on the waterward end. Concrete headwall on the landward end. (USACE-1967). This entry matches the Drainage or Irrigation Structure referenced in O&M manual (HLM 1.53). FS Date: 3/27/2014

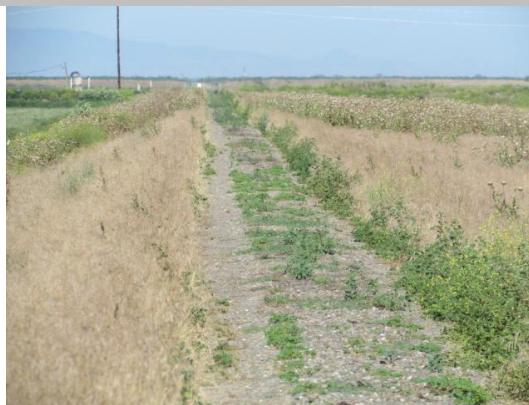
Photo 2 of 2 : UCIP_SP_2016_39251_60876.jpg

Headwall, Pipe, and flapgate on WS toe.

LM Start	0.01	Rating **	M	Issue No.	14
LM End	1.96	Issue Type +	Ma	Location *	CR
Category	Earthen Levee			GPS Latitude/Longitude	
				Start	End
Item	Crown Surface / Depressions / Rutting			36.995388 °	36.995507 °
				-120.408738 °	-120.373592 °
DWR ID	DWR_NA0010_16_s _ 2012_14				
Comment Code					
C1 : Add appropriate material and re-grade the levee to bring the crown above the design elevation.					
Inspector Comment					
Control vegetation and regrade levee crown.

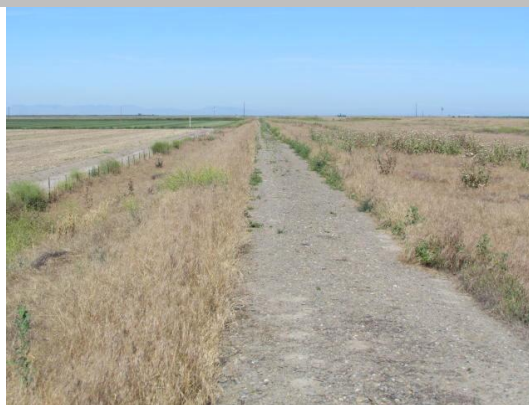
Photo 1 of 1 : SP_2016_NA0010_134_5_20160524_00010.jpg

LM Start	1.43	Rating **	U	Issue No.	5
LM End	1.96	Issue Type +	Ma	Location *	LS
Category	Earthen Levee			GPS Latitude/Longitude	
				Start	End
Item	Vegetation			36.995466 °	36.995487 °
				-120.383089 °	-120.373596 °
DWR ID	DWR_NA0010_16_s _ 2016_5				
Comment Code					
V1 : Control annual grass and weeds on the levee slopes and easements.					
Inspector Comment

Looking west at dense veg on landward slope.

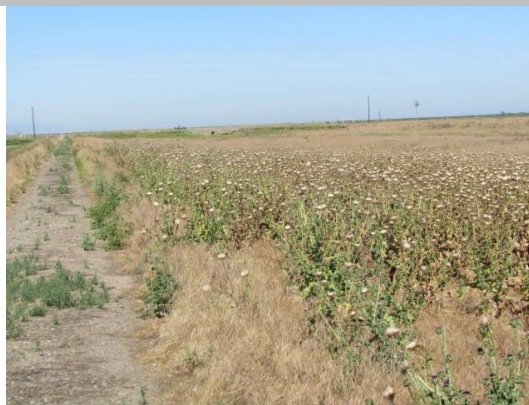
Photo 1 of 1 : SP_2016_NA0010_134_6_20160524_00011.jpg

LM Start	1.43	Rating **	U	Issue No.	6
LM End	1.96	Issue Type +	Ma	Location *	WS
Category	Earthen Levee			GPS Latitude/Longitude	
				Start	End
Item	Vegetation			36.995466 °	36.995487 °
				-120.383089 °	-120.373595 °
DWR ID	DWR_NA0010_16_s _ 2016_6				
Comment Code					
V1 : Control annual grass and weeds on the levee slopes and easements.					
Inspector Comment

Looking west at dense veg on waterward slope.

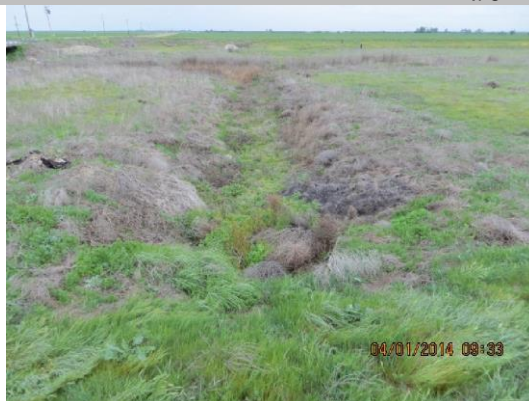
Photo 1 of 2 : UCIP_SP_2016_39529_59681.jpg

LM Start	1.44	Rating **	M	Issue No.	93
LM End	1.44	Issue Type +	En	Location *	WS
Category	Supplemental			GPS Latitude/Longitude	
				Start	End
Item	DWR UCIP Field Study			36.995473 °	36.995473 °
				-120.382872 °	-120.382872 °
DWR ID					
Comment Code					
Inspector Comment					
FS_ID:39529 DS_ID:19915 EP_NO: N/A Repair Type: Non-Urgent Crossing Status: Found UCIP Comments: Dense vegetation buildup at landside toe-- recommend clearing. FIELD_STRUCT_DESC: 30-inch square R.C.B.C. through levee, 8.5 feet below crown. Concrete "U" headwall on waterward end. Two concrete cutoff walls. Flap gate on waterward side. Concrete headwall on landward end. (USACE-1967). This entry matches the Drainage or Irrigation Structure referenced in O&M manual (HLM 1.46). FS Date: 4/1/2014 8:12:00 AM

Concrete headwall on WS toe with channel.

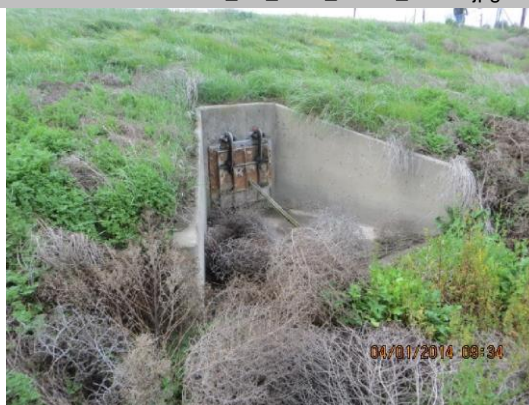
Photo 2 of 2 : UCIP_SP_2016_39529_59680.jpg

LM Start	1.44	Rating **	M	Issue No.	93 (cont)
LM End	1.44	Issue Type +	En	Location *	WS

Flapgate on headwall at WS toe.

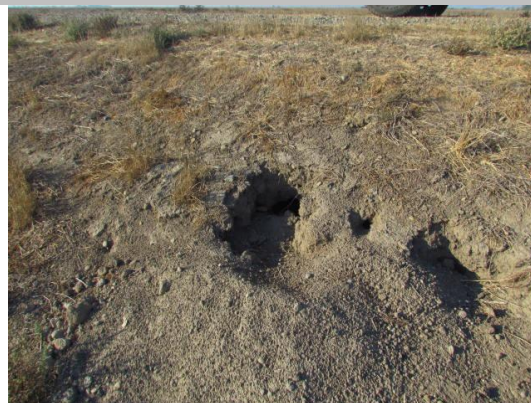
Photo 1 of 2 : SP_2016_NA0010_134_2_20160512_00001.jpg

LM Start	1.77	Rating **	U	Issue No.	2
LM End	1.77	Issue Type +	Ma	Location *	LS
Category	Earthen Levee			GPS Latitude/Longitude	
				Start	End
Item	Animal Control			36.995487 °	36.995487 °
				-120.377054 °	-120.377054 °
DWR ID	DWR_NA0010_16_f_2014_2				
Comment Code					
A3 : No rodents visible, but rodent burrows visible; need to backfill and compact or grout burrows.					
Inspector Comment					
Large rodent holes on landward slope.

Looking at large rodent holes on landward slope.

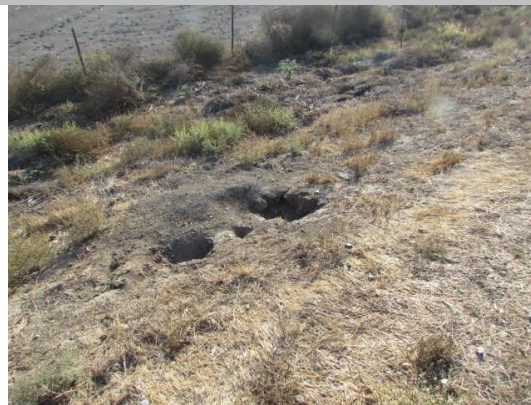
Photo 2 of 2 : SP_2016_NA0010_134_2_20160512_00002.jpg

Looking southwest at several rodent holes on landward slope.

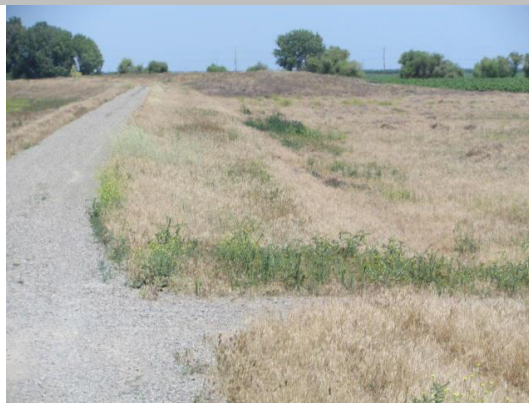
Photo 1 of 1 : SP_2016_NA0010_135_13_20160524_00027.jpg

LM Start	0.00	Rating **	M	Issue No.	13
LM End	16.09	Issue Type +	Ma	Location *	LS
Category	Earthen Levee			GPS Latitude/Longitude	
				Start	End
Item	Vegetation			36.976460 °	36.774431 °
				-120.374695 °	-120.283758 °
DWR ID	DWR_NA0010_17_s_2016_13				
Comment Code					
V1 : Control annual grass and weeds on the levee slopes and easements.					
Inspector Comment

Looking at typical view of landward slope.

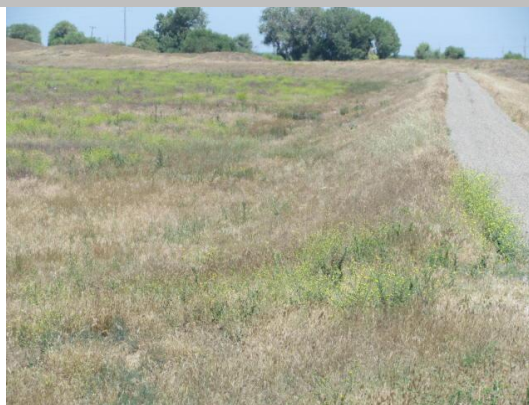
Photo 1 of 1 : SP_2016_NA0010_135_14_20160524_00026.jpg

LM Start	0.00	Rating **	M	Issue No.	14
LM End	16.09	Issue Type +	Ma	Location *	WS
Category	Earthen Levee			GPS Latitude/Longitude	
				Start	End
Item	Vegetation			36.976460 °	36.774431 °
				-120.374695 °	-120.283758 °
DWR ID	DWR_NA0010_17_s_2016_14				
Comment Code					
V1 : Control annual grass and weeds on the levee slopes and easements.					
Inspector Comment

Looking at typical view of waterward slope.

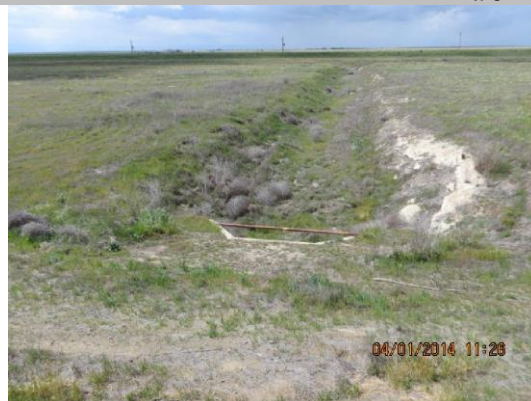
Photo 1 of 2 : UCIP_SP_2016_39531_59710.jpg

Comment Code					
Inspector Comment					
FS_ID:39531 DS_ID:19916 EP_NO: N/A Repair Type: Non-Urgent Crossing Status: Found UCIP Comments: Dense vegetation limits the inspector's visibility to identify signs of pipe failure (leaks) along the landward slope. Recommend removing vegetation along pipe alignment to conduct proper inspection of structure. FIELD_STRUCT_DESC: 48x60-inch R.C.B.C. through the levee, 14.6 feet below the crown. Concrete "U" headwall on the waterward end. Flap gate on the waterward end. Concrete headwall on the landward end. (USACE-1967). This entry matches the Drainage or Irrigation Structure referenced in O&M manual (HLM 2.58). FS Date: 4/1/2014

Concrete headwall at channel on WS toe.

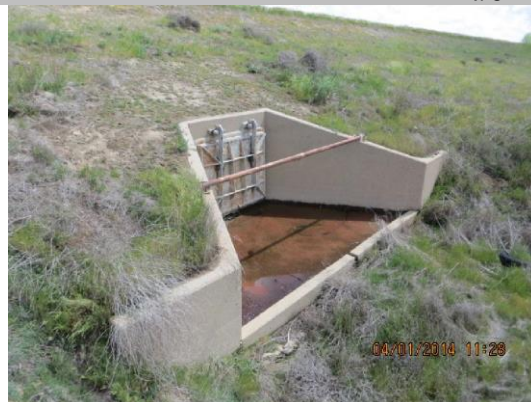
Photo 2 of 2 : UCIP_SP_2016_39531_59711.jpg

Flapgate on Concrete headwall at WS toe.

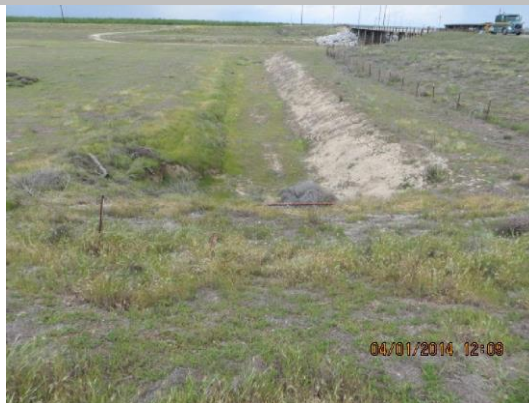
Photo 1 of 2 : UCIP_SP_2016_39532_59723.jpg

LM Start	9.88	Rating **	M	Issue No.	16
LM End	9.88	Issue Type +	En	Location *	LS
Category	Supplemental			GPS Latitude/Longitude	
				Start	End
Item	DWR UCIP Field Study			36.850703 °	36.850703 °
				-120.314154 °	-120.314154 °
DWR ID					
Comment Code					
Inspector Comment					
FS_ID:39532 DS_ID:19917 EP_NO: N/A Repair Type: Non-Urgent Crossing Status: Found UCIP Comments: Dense vegetation limits the inspector's visibility to identify signs of pipe failure (leaks) along the landward slope. Recommend removing vegetation along pipe alignment to conduct proper inspection of structure. FIELD_STRUCT_DESC: 48x60-inch R.C.B.C. through the levee, 15-feet below the crown. Concrete "U" headwall on the waterward end. Concrete headwall on landward end. (USACE-1967). This entry matches the Drainage or Irrigation Structure referenced in O&M manual (HLM 9.89). FS Date: 4/1/2014

Concrete headwall and channel on WS toe.

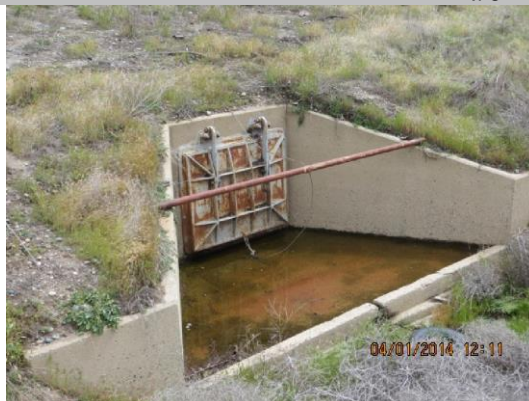
Photo 2 of 2 : UCIP_SP_2016_39532_59724.jpg

Comment Code						
Inspector Comment						
FS_ID:39532						
DS_ID:19917						
EP_NO: N/A						
Repair Type: Non-Urgent						
Crossing Status: Found						
UCIP Comments: Dense vegetation limits the inspector's visibility to identify signs of pipe failure (leaks) along the landward slope.						
Recommend removing vegetation along pipe alignment to conduct proper inspection of structure.						
FIELD_STRUCT_DESC: 48x60-inch R.C.B.C. through the levee, 15-feet below the crown. Concrete "U" headwall on the waterward end. Concrete headwall on landward end. (USACE-1967). This entry matches the Drainage or Irrigation Structure referenced in O&M manual (HLM 9.89).						
FS Date: 4/1/2014

Flapgate on Concrete headwall at WS toe.

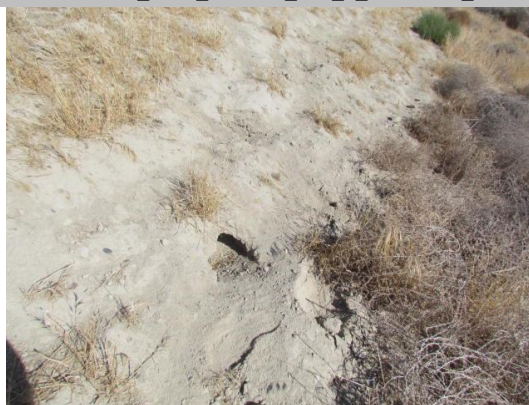
Photo 1 of 2 : SP_2016_NA0010_135_3_20160512_00001.jpg

LM Start	12.34	Rating **	M	Issue No.	3
LM End	12.37	Issue Type +	Ma	Location *	LS
Category	Earthen Levee			GPS Latitude/Longitude	
				Start	End
Item	Animal Control			36.820558 °	36.820155 °
				-120.300616 °	-120.300784 °
DWR ID	DWR_NA0010_17_s_2014_3				
Comment Code					
A3 : No rodents visible, but rodent burrows visible; need to backfill and compact or grout burrows.					
Inspector Comment					
Noted several rodent holes with this reach.

Looking at typical view of rodent holes on landward slope. Fall 2015

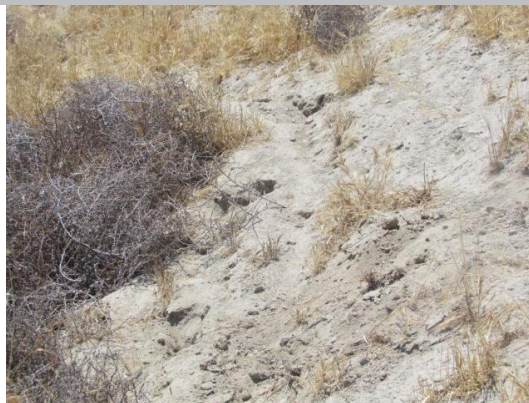
Photo 2 of 2 : SP_2016_NA0010_135_3_20160512_00002.jpg

LM Start	12.34	Rating **	M	Issue No.	3 (cont)	
LM End	12.37	Issue Type +	Ma	Location *	LS	
Category	Earthen Levee			GPS Latitude/Longitude		
				Start		End
Item	Animal Control			36.820558 °		36.820155 °
				-120.300616 °		-120.300784 °
DWR ID	DWR_NA0010_17_s_2014_3					
Comment Code						
A3 : No rodents visible, but rodent burrows visible; need to backfill and compact or grout burrows.						
Inspector Comment						
Noted several rodent holes with this reach.

Looking at several rodent holes on landward slope. Spring 2015

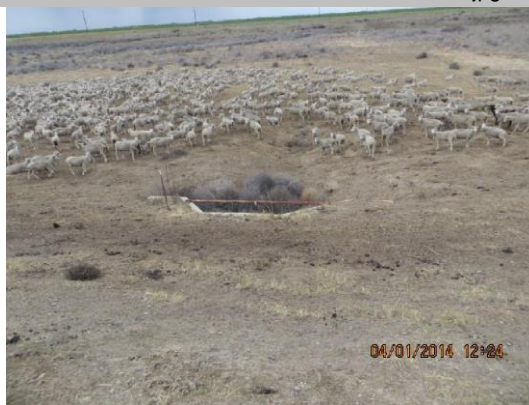
Photo 1 of 2 : UCIP_SP_2016_39533_59727.jpg

LM Start	13.29	Rating **	M	Issue No.	17
LM End	13.29	Issue Type +	En	Location *	LS
Category	Supplemental			GPS Latitude/Longitude	
				Start	End
Item	DWR UCIP Field Study			36.807509 °	36.807509 °
				-120.306231 °	-120.306231 °
DWR ID					
Comment Code					
Inspector Comment					
FS_ID:39533 DS_ID:19918 EP_NO: N/A Repair Type: Non-Urgent Crossing Status: Found UCIP Comments: Some vegetation buildup at inlet--recommend clearing. FIELD_STRUCT_DESC: 48x60-inch R.C.B.C. through the levee, 15.3 feet below the crown. Concrete "U" headwall on the waterward end. Flap gate on the waterward end. Concrete headwall on the landward end. (USACE-1967). This entry matches the Drainage or Irrigation Structure referenced in O&M manual (HLM 13.30). FS Date: 4/1/2014

Concrete headwall on WS toe.

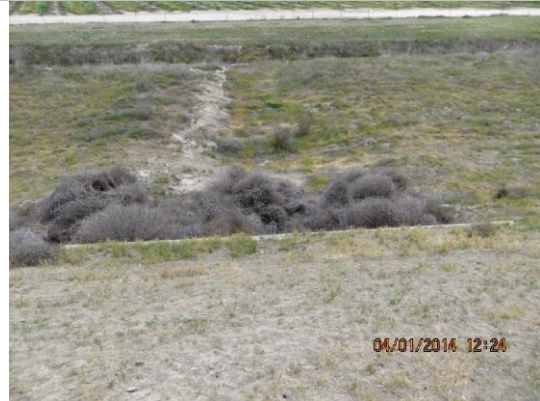
Photo 2 of 2 : UCIP_SP_2016_39533_59726.jpg

LM Start	13.29	Rating **	M	Issue No.	17 (cont)
LM End	13.29	Issue Type +	En	Location *	LS
Category	Supplemental			GPS Latitude/Longitude	
				Start	End
Item	DWR UCIP Field Study			36.807509 °	36.807509 °
				-120.306231 °	-120.306231 °
DWR ID					
Comment Code					
Inspector Comment					
FS_ID:39533 DS_ID:19918 EP_NO: N/A Repair Type: Non-Urgent Crossing Status: Found UCIP Comments: Some vegetation buildup at inlet--recommend clearing. FIELD_STRUCT_DESC: 48x60-inch R.C.B.C. through the levee, 15.3 feet below the crown. Concrete "U" headwall on the waterward end. Flap gate on the waterward end. Concrete headwall on the landward end. (USACE-1967). This entry matches the Drainage or Irrigation Structure referenced in O&M manual (HLM 13.30). FS Date: 4/1/2014

Concrete headwall on LS toe.

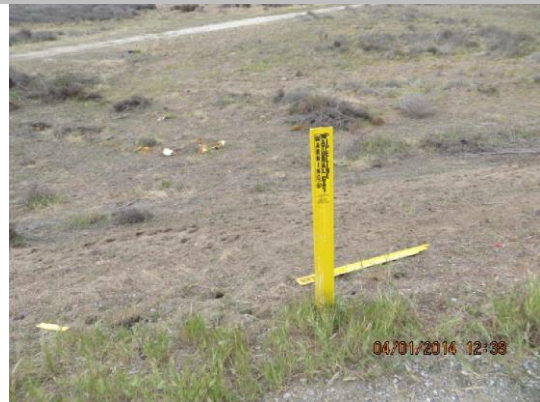
Photo 1 of 2 : UCIP_SP_2016_41406_71490.jpg

LM Start	14.38	Rating **	M	Issue No.	20
LM End	14.38	Issue Type +	En	Location *	LS
Category	Supplemental			GPS Latitude/Longitude	
				Start	End
Item	DWR UCIP Field Study			36.793318 °	36.793318 °
				-120.302138 °	-120.302138 °
DWR ID					
Comment Code					
Inspector Comment					
FS_ID:41406					
DS_ID:24850					
EP_NO: N/A					
Repair Type: Non-Urgent					
Crossing Status: Indicator Found					
UCIP Comments: No permit identified for this crossing.					
FIELD_STRUCT_DESC: Gas line through the levee at an unknown depth. Gas line markers on both shoulders.					
FS Date: 4/1/2014

Gasline marker on WS slope..

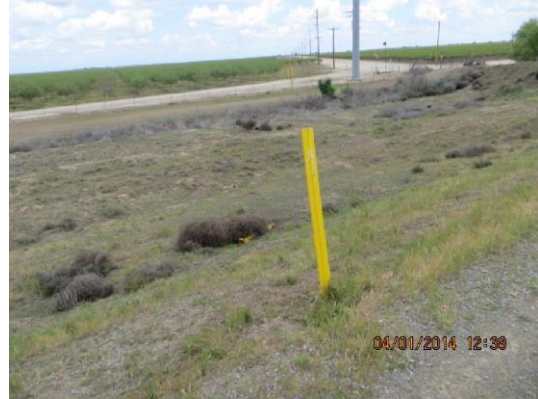
Photo 2 of 2 : UCIP_SP_2016_41406_71489.jpg

LM Start	14.38	Rating **	M	Issue No.	20 (cont)	
LM End	14.38	Issue Type +	En	Location *	LS	
Category	Supplemental			GPS Latitude/Longitude		
				Start	End	
Item	DWR UCIP Field Study			36.793318 °	36.793318 °	
				-120.302138 °	-120.302138 °	
DWR ID						
Comment Code						
Inspector Comment						
FS_ID:41406						
DS_ID:24850						
EP_NO: N/A						
Repair Type: Non-Urgent						
Crossing Status: Indicator Found						
UCIP Comments: No permit identified for this crossing.						
FIELD_STRUCT_DESC: Gas line through the levee at an unknown						
depth. Gas line markers on both shoulders.						
FS Date: 4/1/2014

Gasline marker on LS shoulder.

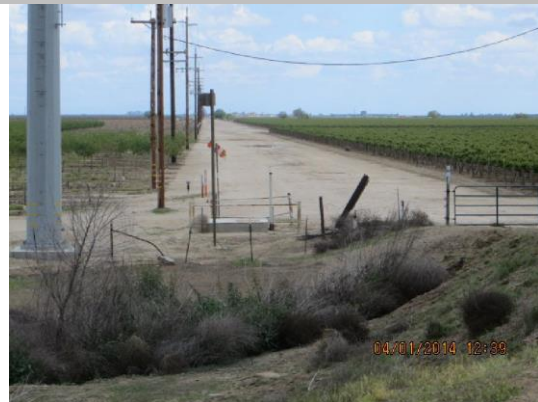
Photo 1 of 2 : UCIP_SP_2016_39534_59742.jpg

LM Start	14.39	Rating **	U	Issue No.	18
LM End	14.39	Issue Type +	En	Location *	LS
Category	Supplemental			GPS Latitude/Longitude	
				Start	End
Item	DWR UCIP Field Study			36.793195 °	36.793195 °
				-120.302028 °	-120.302028 °
DWR ID					
Comment Code					
Inspector Comment					
FS_ID:39534 DS_ID:19562 EP_NO: 18568 Repair Type: Urgent Crossing Status: Indicator Found UCIP Comments: Need to contact owner to confirm and obtain status of crossing. Markers misleading--unable to confirm if markers correspond to this crossing. Need markers at levee. FIELD_STRUCT_DESC: 30-inch steel gas pipeline through the levee approximately 60-feet below the crown. Location markers on waterside and landside. Provide field description of crossing. (Permit No. 18568-2010) FS Date: 4/1/2014

Gasline marker and concrete sump off LS toe.

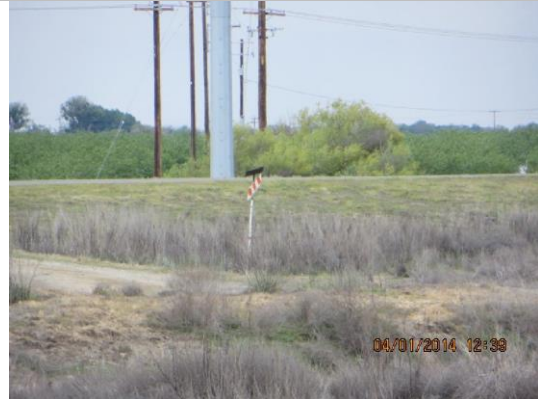
Photo 2 of 2 : UCIP_SP_2016_39534_59741.jpg

LM Start	14.39	Rating **	U	Issue No.	18 (cont)
LM End	14.39	Issue Type +	En	Location *	LS
Category	Supplemental			GPS Latitude/Longitude	
				Start	End
Item	DWR UCIP Field Study			36.793195 °	36.793195 °
				-120.302028 °	-120.302028 °
DWR ID					
Comment Code					
Inspector Comment					
FS_ID:39534 DS_ID:19562 EP_NO: 18568 Repair Type: Urgent Crossing Status: Indicator Found UCIP Comments: Need to contact owner to confirm and obtain status of crossing. Markers misleading--unable to confirm if markers correspond to this crossing. Need markers at levee. FIELD_STRUCT_DESC: 30-inch steel gas pipeline through the levee approximately 60-feet below the crown. Location markers on waterside and landside. Provide field description of crossing. (Permit No. 18568-2010) FS Date: 4/1/2014

Gasline marker visible in channel off WS toe.

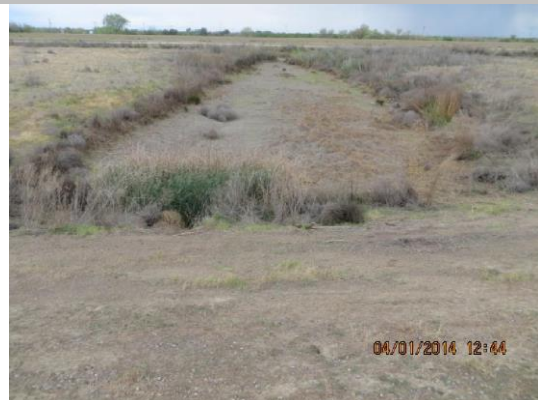
Photo 1 of 2 : UCIP_SP_2016_39535_59745.jpg

LM Start	14.69	Rating **	M	Issue No.	19
LM End	14.69	Issue Type +	En	Location *	LS
Category	Supplemental			GPS Latitude/Longitude	
				Start	End
Item	DWR UCIP Field Study			36.789066 °	36.789066 °
				-120.300644 °	-120.300644 °
DWR ID					
Comment Code					
Inspector Comment					
FS_ID:39535 DS_ID:19920 EP_NO: N/A Repair Type: Non-Urgent Crossing Status: Found UCIP Comments: Heavy vegetation buildup at LS toe--recommend clearing. FIELD_STRUCT_DESC: 30-inch square R.C.B.C. through the levee, 14.0 feet below the crown. Concrete "U" headwall on the waterward end. Flap gate on the waterward end. Concrete headwall on landward end. (USACE-1967). This entry matches the Drainage or Irrigation Structure referenced in O&M manual (HLM 14.69). FS Date: 4/1/2014

Concrete headwall at WS toe.

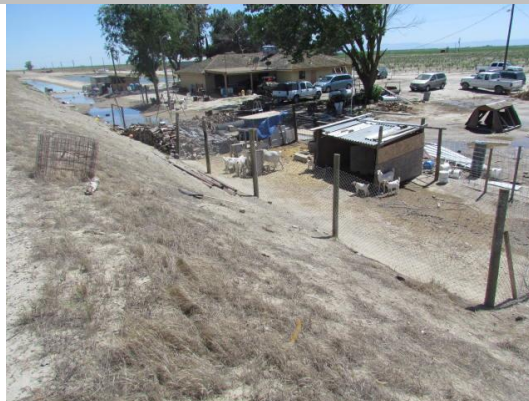
Photo 1 of 1 : SP_2016_NA0010_137_12_20160524_00017.jpg

LM Start	1.52	Rating **	M	Issue No.	12
LM End	1.52	Issue Type +	En	Location *	LS
Category	Earthen Levee			GPS Latitude/Longitude	
				Start	End
Item	Encroachments			36.955081 °	36.955081 °
				-120.353025 °	-120.353025 °
DWR ID	DWR_NA0010_18_s_2016_12				
Comment Code					
FE : Fence					
Inspector Comment					
Animal pen at landward toe.

Looking west at new animal pen at landward toe.

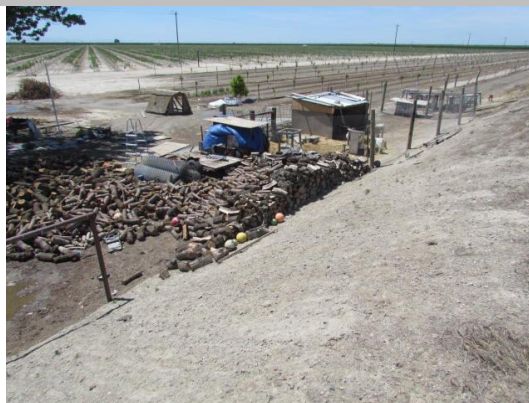
Photo 1 of 1 : SP_2016_NA0010_137_3_20160524_00018.jpg

LM Start	1.53	Rating **	U	Issue No.	3
LM End	1.53	Issue Type +	En	Location *	LS
Category	Earthen Levee			GPS Latitude/Longitude	
				Start	End
Item	Encroachments			36.954907 °	36.954907 °
				-120.352920 °	-120.352920 °
DWR ID	DWR_NA0010_18_s_2016_3				
Comment Code					
FW : Firewood					
Inspector Comment					
Firewood stock pile at landward toe.

Looking northwest at firewood stock pile at landward toe.

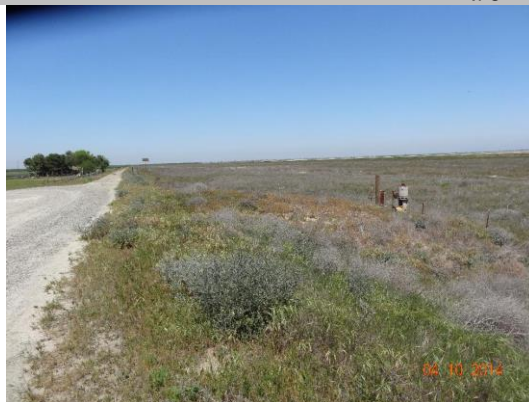
Photo 2 of 2 : UCIP_SP_2016_39503_66657.jpg

Comment Code					
Inspector Comment					
FS_ID:39503 DS_ID:19925 EP_NO: 6603 Repair Type: Non-Urgent Crossing Status: Found UCIP Comments: Need to contact owner. Appears abandoned--good candidate for video or pressure inspection. This crossings is the same age as the pipe that has failed immediately upstream. FIELD_STRUCT_DESC: 15-inch steel pipe through the levee, 4.3 feet below the crown. Electrical conduit through the levee, 4.3 feet below the crown. Siphon breaker on landward shoulder. 36-inch concrete standpipe on landward berm. Inlet facility on waterward bank consisting of pump, 42-inch concrete standpipe, and 20-inch concrete channel intake pipe with cutoff wall. (Permit No. 6603-1970) FS Date: 4/10/2014

View of waterward side.

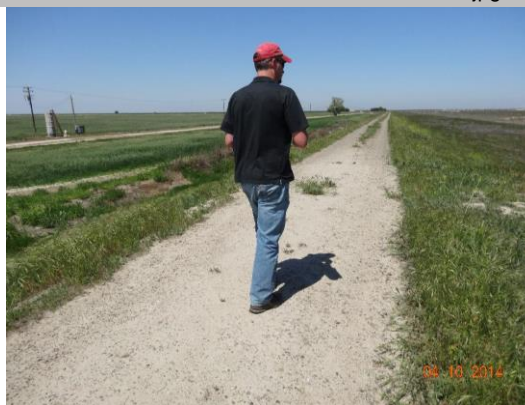
Photo 2 of 2 : UCIP_SP_2016_43089_60559.jpg

FS_ID:43089
DS_ID:19926
EP_NO: 6603
Repair Type: Urgent
Crossing Status: Found
UCIP Comments: Subsidence present along pipe alignment on landward side. Modified crossing-- worked done on landward side. Need to contact owner to determine permit authorizing work. Dense vegetation on landward side--tall grass. Pipe wall cut and new pipe sleeved on landward side.
FIELD_STRUCT_DESC: 15-inch steel pipe through the levee, 3.7 feet below the crown. Electrical conduit through the levee, 3.7 feet below the crown. Siphon breaker on landward shoulder. 36-inch concrete standpipe on landward berm. Inlet facility on waterward bank consisting of pump, 42-inch concrete standpipe, and 20-inch concrete channel intake pipe with cutoff wall. (Permit No. 6603-1970)
FS Date: 4/10/2014

View of levee crown at crossing.

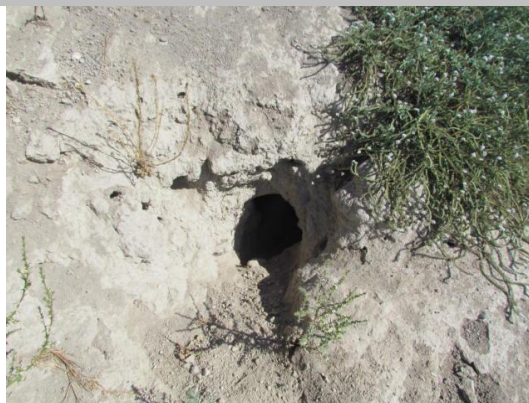
Photo 2 of 2 : SP_2016_NA0010_137_8_20160512_00004.jpg

Looking at close-up view of large rodent hole on landward slope.

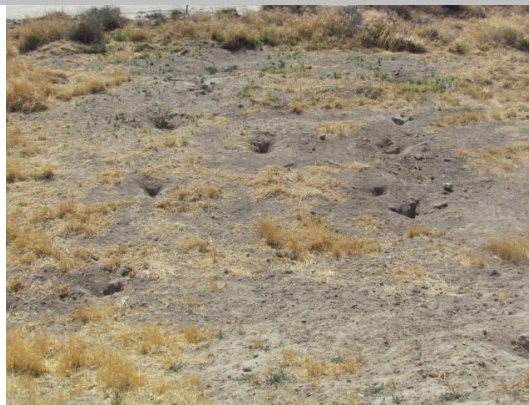
Photo 1 of 1 : SP_2016_NA0010_137_1_20160512_00001.jpg

LM Start	5.89	Rating **	M	Issue No.	1
LM End	5.89	Issue Type +	Ma	Location *	LS
Category	Earthen Levee			GPS Latitude/Longitude	
				Start	End
Item	Animal Control			36.895175 °	36.895175 °
				-120.327632 °	-120.327632 °
DWR ID	DWR_NA0010_18_s_2015_1				
Comment Code					
A3 : No rodents visible, but rodent burrows visible; need to backfill and compact or grout burrows.					
Inspector Comment					
Several large rodent holes noted on landward slope and berm within this section.

Looking at several rodent holes on landward slope.

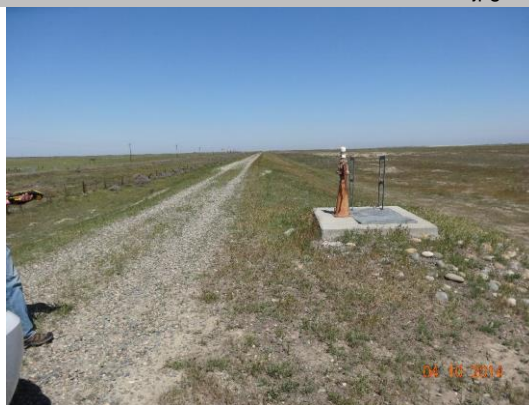
Photo 1 of 2 : UCIP_SP_2016_36843_67202.jpg

LM Start	7.54	Rating **	M	Issue No.	13
LM End	7.54	Issue Type +	En	Location *	WS
Category	Supplemental			GPS Latitude/Longitude	
				Start	End
Item	DWR UCIP Field Study			36.872431 °	36.872431 °
				-120.319415 °	-120.319415 °
DWR ID					
Comment Code					
Inspector Comment					
FS_ID:36843 DS_ID:19930 EP_NO: N/A Repair Type: Non-Urgent Crossing Status: Found UCIP Comments: CMP crossing is distorted on waterward side. Debris scattered on landward side. Sediment deposit inside crossing visible from landward side. Recommend removing debris from landward side. FIELD_STRUCT_DESC: 42-inch concrete pipe through the levee, 19.0 feet below the crown. Gate structure on waterward shoulder. Pipe section on waterward side is corrugated metal and pipe section on lanward side is reinforced concrete. (Permit No. 13548-1984, New Stone Water District) FS Date: 4/10/2014

Overview of levee crown at crossing--slide gate inside concrete box located on waterward shoulder.

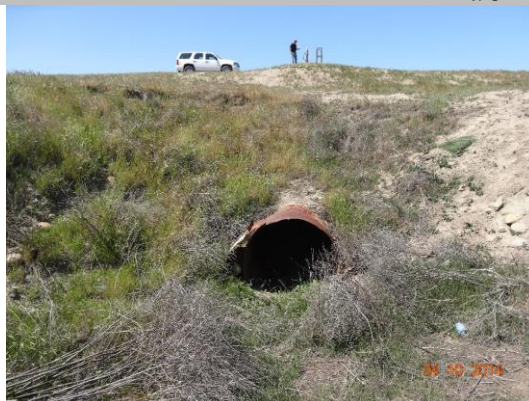
Photo 2 of 2 : UCIP_SP_2016_36843_67205.jpg

LM Start	7.54	Rating **	M	Issue No.	13 (cont)	
LM End	7.54	Issue Type +	En	Location *	WS	
Category	Supplemental			GPS Latitude/Longitude		
				Start		End
Item	DWR UCIP Field Study			36.872431 °	36.872431 °	
				-120.319415 °	-120.319415 °	
DWR ID						
Comment Code						
Inspector Comment						
FS_ID:36843 DS_ID:19930 EP_NO: N/A Repair Type: Non-Urgent Crossing Status: Found UCIP Comments: CMP crossing is distorted on waterward side. Debris scattered on landward side. Sediment deposit inside crossing visible from landward side. Recommend removing debris from landward side. FIELD_STRUCT_DESC: 42-inch concrete pipe through the levee, 19.0 feet below the crown. Gate structure on waterward shoulder. Pipe section on waterward side is corrugated metal and pipe section on lanward side is reinforced concrete. (Permit No. 13548-1984, New Stone Water District) FS Date: 4/10/2014

Pipe section distorted on waterward side.

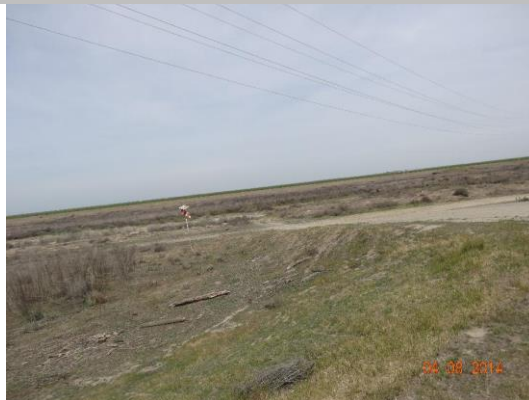
Photo 1 of 2 : UCIP_SP_2016_39505_67226.jpg

LM Start	13.59	Rating **	M	Issue No.	15
LM End	13.59	Issue Type +	En	Location *	WS
Category	Supplemental			GPS Latitude/Longitude	
				Start	End
Item	DWR UCIP Field Study			36.792684 °	36.792684 °
				-120.304542 °	-120.304542 °
DWR ID					
Comment Code					
Inspector Comment					
FS_ID:39505 DS_ID:19932 EP_NO: N/A Repair Type: Non-Urgent Crossing Status: Indicator Found UCIP Comments: Multiple markers visible along waterward and landward sides unable to confirm how many crossings go through levee. Need to contact owner to obtain additional details on crossings. FIELD_STRUCT_DESC: 6-inch gas line through the levee. Extends underneath the channel. FS Date: 4/8/2014

Markers visible on waterward side.

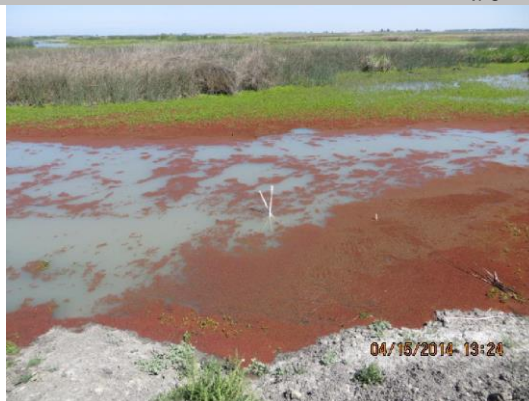
Photo 1 of 2 : UCIP_SP_2016_39874_61060.jpg

LM Start	0.10	Rating **	U	Issue No.	263
LM End	0.10	Issue Type +	En	Location *	WS
Category	Supplemental			GPS Latitude/Longitude	
				Start	End
Item	DWR UCIP Field Study			37.207039 °	37.207039 °
				-120.696255 °	-120.696255 °
DWR ID					
Comment Code					
Inspector Comment					
FS_ID:39874					
DS_ID:19933					
EP_NO: N/A					
Repair Type: Urgent					
Crossing Status: Found					
UCIP Comments: No actuator wheel on slide gate at WS shoulder.					
FIELD_STRUCT_DESC: 24-inch CM stormdrain pipe through the levee, 14.8 feet below the crown. Slide gate inside 36-inch CM pipe riser in the waterward slope. Concrete "U" headwalls on both ends. (USACE-1967). This entry matches the Drainage or Irrigation Structure referenced in O&M manual (HLM 0.10).					
FS Date: 4/15/2014

PVC pipes sticking up out of channel likely indicate pipe location on WS toe.

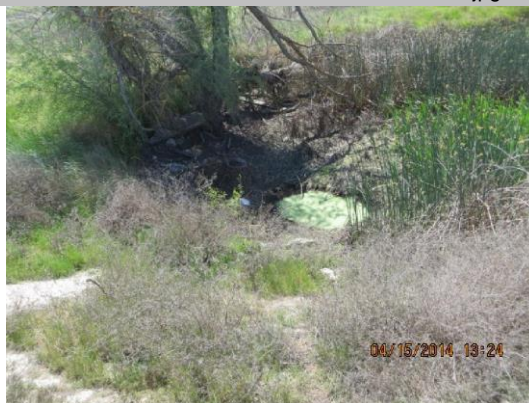
Photo 2 of 2 : UCIP_SP_2016_39874_61061.jpg

Concrete headwall at toe of LS slope.

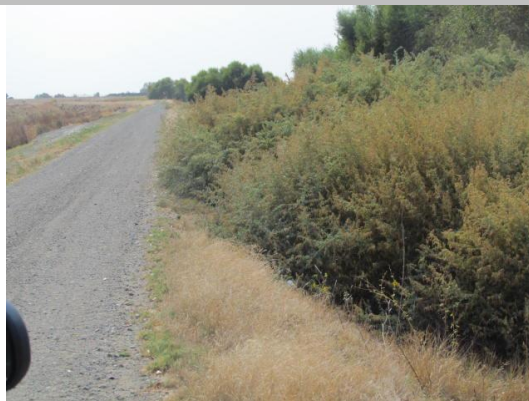
Photo 1 of 2 : SP_2016_NA0010_138_21_20160512_00009.jpg

LM Start	0.53	Rating **	U	Issue No.	21
LM End	0.53	Issue Type +	Ma	Location *	LS
Category	Earthen Levee			GPS Latitude/Longitude	
				Start	End
Item	Vegetation			37.213006 °	37.213006 °
				-120.698019 °	-120.698019 °
DWR ID	DWR_NA0010_22A_f _ 2014_21				
Comment Code					
V2 : Remove the wild growth other than native grasses from the levee slopes.					
Inspector Comment					
Dense vegetation on landward slope.

Looking at dense vegetation on landward slope. Fall 2015

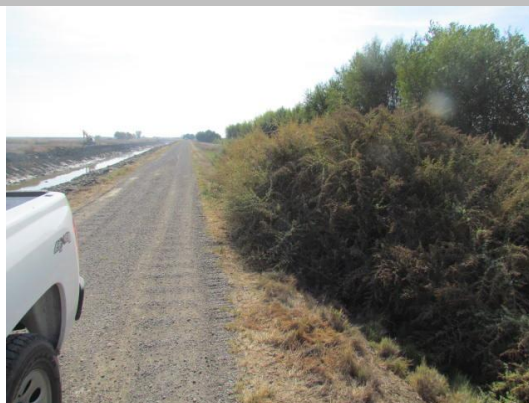
Photo 2 of 2 : SP_2016_NA0010_138_21_20160512_00010.jpg

Looking south at dense vegetation on landward slope. Spring 2015

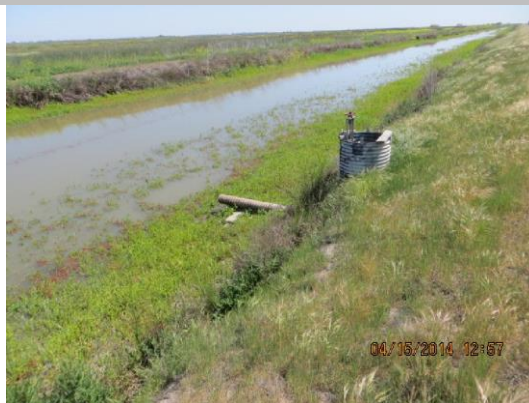
Photo 1 of 2 : UCIP_SP_2016_33733_61030.jpg

LM Start	1.57	Rating **	M	Issue No.	261
LM End	1.57	Issue Type +	En	Location *	WS
Category	Supplemental			GPS Latitude/Longitude	
				Start	End
Item	DWR UCIP Field Study			37.227588 °	37.227588 °
				-120.700945 °	-120.700945 °
DWR ID					
Comment Code					
Inspector Comment					
FS_ID:33733					
DS_ID:19936					
EP_NO: N/A					
Repair Type: Non-Urgent					
Crossing Status: Found					
UCIP Comments: Slide gate rusted and does not function. Headwall buried at LS toe. Pipe appears abandoned and if so should be done so properly.					
FIELD_STRUCT_DESC: 8-inch CM irrigation pipe through levee, 7.0-feet below the crown. Slide gate inside 36-inch CM pipe riser in the waterward slope. Concrete headwall on the landward end. (USACE-1967). This entry matches the Drainage or Irrigation Structure referenced in O&M manual (HLM 1.57).					
FS Date: 4/15/2014

Pipe and CMP riser with slide gate visible on WS slope.

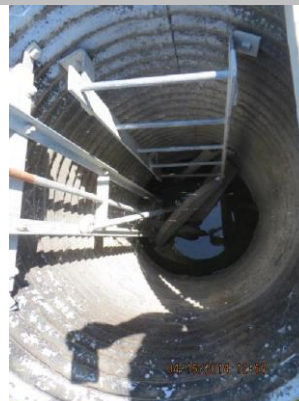
Photo 2 of 2 : UCIP_SP_2016_33733_61029.jpg

LM Start	1.57	Rating **	M	Issue No.	261 (cont)	
LM End	1.57	Issue Type +	En	Location *	WS	
Category	Supplemental			GPS Latitude/Longitude		
				Start		End
Item	DWR UCIP Field Study			37.227588 °	37.227588 °	
				-120.700945 °	-120.700945 °	
DWR ID						
Comment Code						
Inspector Comment						
FS_ID:33733 DS_ID:19936 EP_NO: N/A Repair Type: Non-Urgent Crossing Status: Found UCIP Comments: Slide gate rusted and does not function. Headwall buried at LS toe. Pipe appears abandoned and if so should be done so properly. FIELD_STRUCT_DESC: 8-inch CM irrigation pipe through levee, 7.0-feet below the crown. Slide gate inside 36-inch CM pipe riser in the waterward slope. Concrete headwall on the landward end. (USACE-1967). This entry matches the Drainage or Irrigation Structure referenced in O&M manual (HLM 1.57). FS Date: 4/15/2014

Inside CMP riser on WS shoulder.

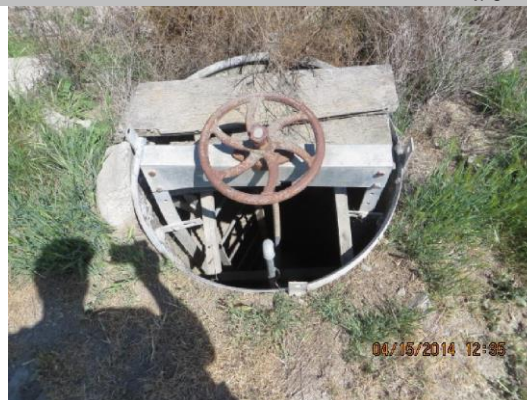
Photo 1 of 2 : UCIP_SP_2016_33732_61026.jpg

LM Start	2.71	Rating **	M	Issue No.	260
LM End	2.71	Issue Type +	En	Location *	WS
Category	Supplemental			GPS Latitude/Longitude	
				Start	End
Item	DWR UCIP Field Study			37.243501 °	37.243501 °
				-120.706773 °	-120.706773 °
DWR ID					
Comment Code					
Inspector Comment					
FS_ID:33732 DS_ID:19937 EP_NO: N/A Repair Type: Non-Urgent Crossing Status: Found UCIP Comments: Slide gate does not function and should be repaired. Headwall at LS toe not found. FIELD_STRUCT_DESC: 24-inch CM irrigation pipe through the levee, 7.5-feet below the crown. Slide gate inside 36-inch CM pipe riser in the waterward slope. Concrete "U" headwall on the landward end. (USACE-1967). This entry matches the Drainage or Irrigation Structure referenced in O&M manual (HLM 2.72). FS Date: 4/15/2014

Slidegate in CMP riser on WS shoulder. (Note: actuator does not work).

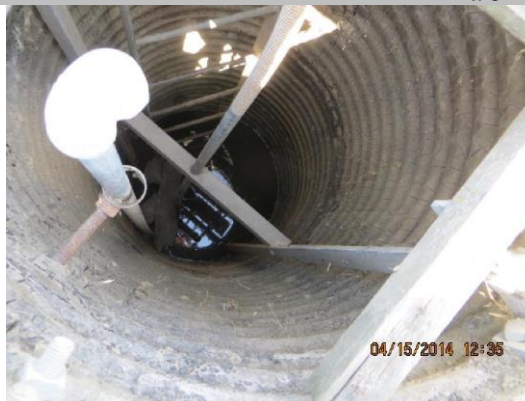
Photo 2 of 2 : UCIP_SP_2016_33732_61024.jpg

LM Start	2.71	Rating **	M	Issue No.	260 (cont)
LM End	2.71	Issue Type +	En	Location *	WS
Category	Supplemental			GPS Latitude/Longitude	
				Start	End
Item	DWR UCIP Field Study			37.243501 °	37.243501 °
				-120.706773 °	-120.706773 °
DWR ID					
Comment Code					
Inspector Comment					
FS_ID:33732					
DS_ID:19937					
EP_NO: N/A					
Repair Type: Non-Urgent					
Crossing Status: Found					
UCIP Comments: Slide gate does not function and should be repaired.					
Headwall at LS toe not found.					
FIELD_STRUCT_DESC: 24-inch CM irrigation pipe through the levee,					
7.5-feet below the crown. Slide gate inside 36-inch CM pipe riser in the					
waterward slope. Concrete "U" headwall on the landward end. (USACE-					
1967). This entry matches the Drainage or Irrigation Structure					
referenced in O&M manual (HLM 2.72).					
FS Date: 4/15/2014

Inside CMP riser on WS shoulder.

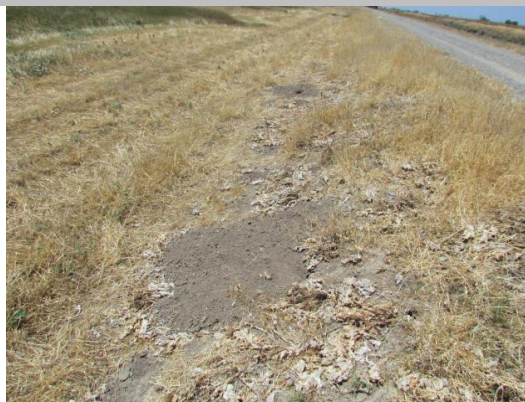
Photo 1 of 1 : SP_2016_NA0010_138_15_20160512_00008.jpg

LM Start	2.86	Rating **	M	Issue No.	15
LM End	3.05	Issue Type +	Ma	Location *	LS
Category	Earthen Levee			GPS Latitude/Longitude	
				Start	End
Item	Animal Control			37.245431 °	37.247343 °
				-120.707990 °	-120.710362 °
DWR ID	DWR_NA0010_22A_s_2014_15				
Comment Code					
A3 : No rodents visible, but rodent burrows visible; need to backfill and compact or grout burrows.					
Inspector Comment					
Noted several rodent holes on landward slope and toe.

Looking at several rodent holes on landward slope.

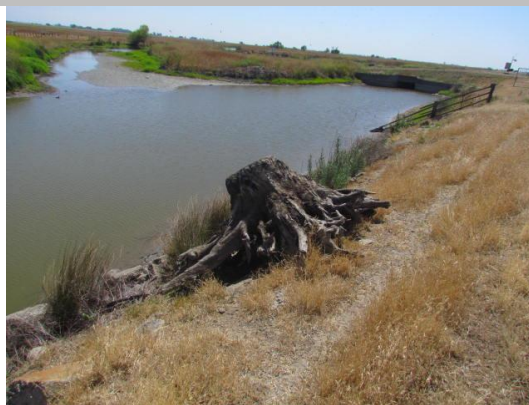
Photo 1 of 1 : SP_2016_NA0010_138_259_20160512_00012.jpg

LM Start	3.80	Rating **	M	Issue No.	259
LM End	3.80	Issue Type +	Ma	Location *	WS
Category	Earthen Levee			GPS Latitude/Longitude	
				Start	End
Item	Encroachments			37.255067 °	37.255067 °
				-120.719910 °	-120.719910 °
DWR ID	DWR_NA0010_22A_s_2015_259				
Comment Code					
TR : Tree or limb					
Inspector Comment					
Dead tree stump on waterward slope.

Looking east at dead stump on waterward slope.

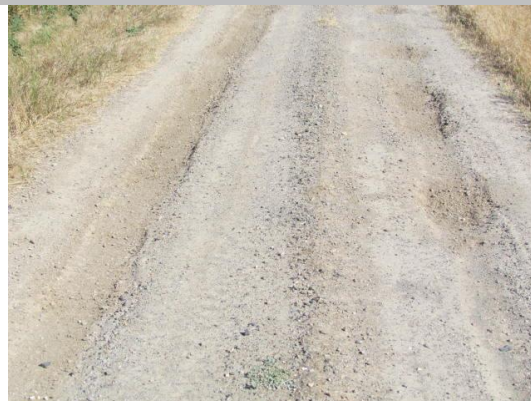
Photo 1 of 1 : SP_2016_NA0010_138_10_20160524_00025.jpg

LM Start	3.82	Rating **	M	Issue No.	10
LM End	5.09	Issue Type +	Ma	Location *	CR
Category	Earthen Levee			GPS Latitude/Longitude	
				Start	End
Item	Crown Surface / Depressions / Rutting			37.255246°	37.267962°
				-120.720110°	-120.736909°
DWR ID	DWR_NA0010_22A_s_2012_10				
Comment Code					
C2 : Repair depressions or ruts in the crown or slope.					
Inspector Comment

Looking west at typical rutting on levee crown.

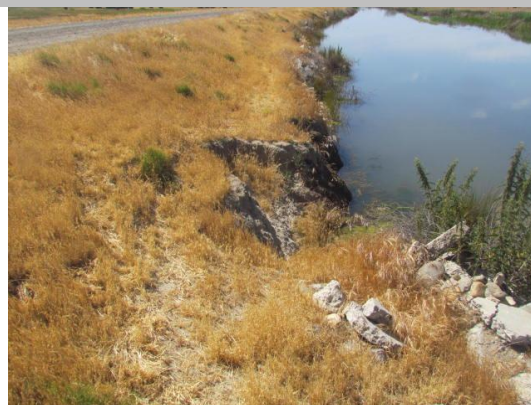
Photo 1 of 1 : SP_2016_NA0010_138_12_20160512_00007.jpg

LM Start	5.03	Rating **	M	Issue No.	12
LM End	5.03	Issue Type +	Ma	Location *	WS
Category	Earthen Levee			GPS Latitude/Longitude	
				Start	End
Item	Slope Stability			37.267271 °	37.267271 °
				-120.736067 °	-120.736067 °
DWR ID	DWR_NA0010_22A_s_2014_12				
Comment Code					
S2 : Repair the levee slope damaged by foot traffic and prevent access where possible.					
Inspector Comment					
Slope damage caused by animal traffic.

Looking south at slope damage cause by animal traffic on waterside slope.

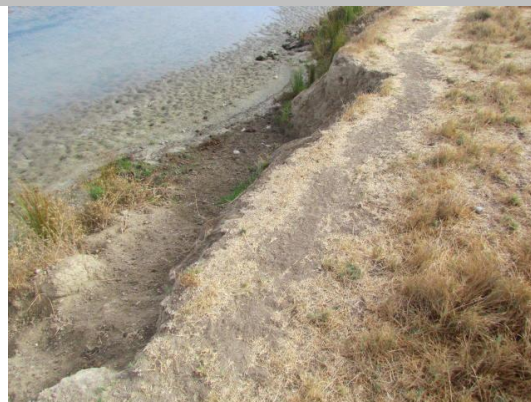
Photo 1 of 2 : SP_2016_NA0010_138_4_20160512_00001.jpg

LM Start	5.05	Rating **	M	Issue No.	4
LM End	5.05	Issue Type +	Ma	Location *	WS
Category	Earthen Levee			GPS Latitude/Longitude	
				Start	End
Item	Erosion / Bank Caving			37.267516 °	37.267516 °
				-120.736401 °	-120.736401 °
DWR ID	DWR_NA0010_22A_f_2013_4				
Comment Code					
E2 : Schedule repair of erosion site prior to the next inspection.					
Inspector Comment					
Erosion caused by animal traffic.

Looking southeast at livestock erosion on waterward toe.

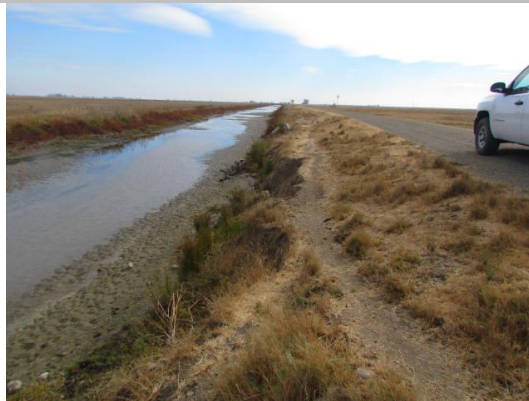
Photo 2 of 2 : SP_2016_NA0010_138_4_20160512_00002.jpg

LM Start	5.05	Rating **	M	Issue No.	4 (cont)	
LM End	5.05	Issue Type +	Ma	Location *	WS	
Category	Earthen Levee			GPS Latitude/Longitude		
				Start		End
Item	Erosion / Bank Caving			37.267516 °		37.267516 °
				-120.736401 °		-120.736401 °
DWR ID	DWR_NA0010_22A_f_2013_4					
Comment Code						
E2 : Schedule repair of erosion site prior to the next inspection.						
Inspector Comment						
Erosion caused by animal traffic.

Looking south livestock erosion on waterward toe.

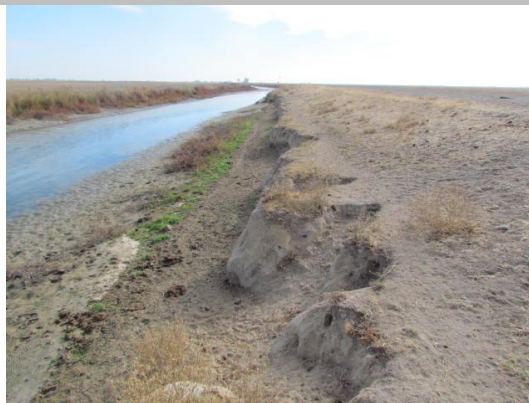
Photo 1 of 2 : SP_2016_NA0010_138_6_20160512_00005.jpg

LM Start	5.14	Rating **	M	Issue No.	6
LM End	5.20	Issue Type +	Ma	Location *	WS
Category	Earthen Levee			GPS Latitude/Longitude	
				Start	End
Item	Animal Control			37.268492 °	37.269133 °
				-120.737493 °	-120.738208 °
DWR ID	DWR_NA0010_22A_s_2012_6				
Comment Code					
A2 : Repair the levee slope damaged by livestock and prevent large animal access.					
Inspector Comment					
Slope damage caused by livestock on waterside toe.

Looking south at livestock erosion on waterward toe.

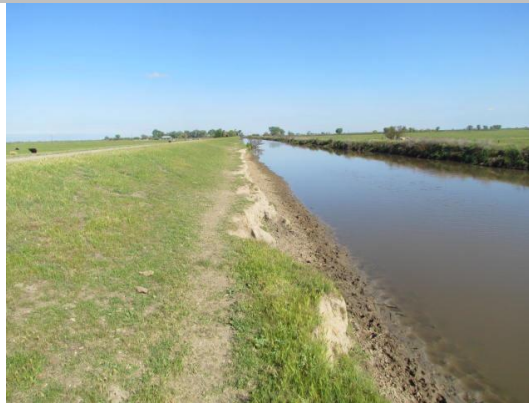
Photo 2 of 2 : SP_2016_NA0010_138_6_20160512_00006.jpg

LM Start	5.14	Rating **	M	Issue No.	6 (cont)
LM End	5.20	Issue Type +	Ma	Location *	WS

Looking north at livestock erosion along waterside slope and toe.

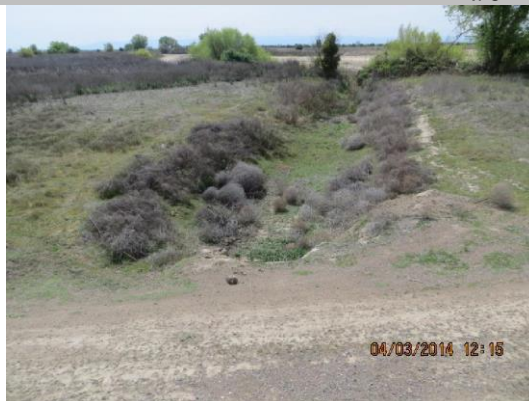
Photo 1 of 2 : UCIP_SP_2016_39537_59860.jpg

LM Start	0.21	Rating **	M	Issue No.	36
LM End	0.21	Issue Type +	En	Location *	WS
Category	Supplemental			GPS Latitude/Longitude	
				Start	End
Item	DWR UCIP Field Study			36.772713 °	36.772713 °
				-120.280670 °	-120.280670 °
DWR ID					
Comment Code					
Inspector Comment					
FS_ID:39537 DS_ID:19945 EP_NO: N/A Repair Type: Non-Urgent Crossing Status: Found UCIP Comments: Excessive vegetation at inlet--recommend clearing. FIELD_STRUCT_DESC: 30-inch square R.C.B.C. through the levee 13.0 feet below the crown. Concrete "U" headwall on the waterward end. Flap gate on the waterward end. Concrete headwall on the landward end. (USACE-1967). This entry matches the Drainage or Irrigation Structure referenced in O&M manual (HLM 0.21). Cleaned and rehabilitated under Permit No. 13085 (1981). FS Date: 4/3/2014

Concrete headwall on WS toe at channel.

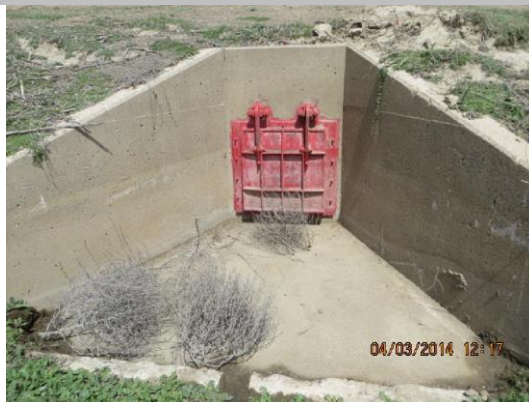
Photo 2 of 2 : UCIP_SP_2016_39537_59859.jpg

LM Start	0.21	Rating **	M	Issue No.	36 (cont)
LM End	0.21	Issue Type +	En	Location *	WS

Flapgate on Concrete headwall at WS toe.

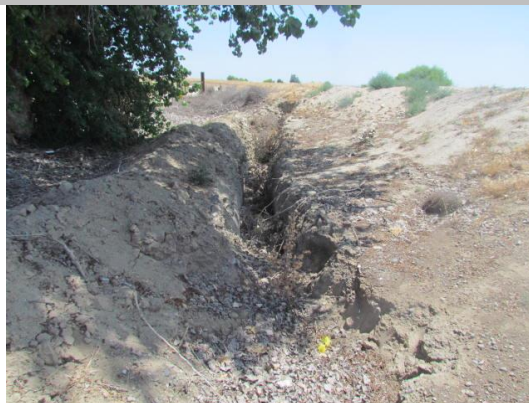
Photo 1 of 3 : SP_2016_NA0010_139_29_20160512_00022.jpg

LM Start	1.53	Rating **	U	Issue No.	29
LM End	1.53	Issue Type +	En	Location *	LS
Category	Earthen Levee			GPS Latitude/Longitude	
				Start	End
Item	Encroachments			36.772041 °	36.772041 °
				-120.259549 °	-120.259549 °
DWR ID	DWR_NA0010_23_f_2014_29				
Comment Code					
DT : Ditch					
Inspector Comment					
Trench at landward toe. Trench is ten to twelve inches wide and twenty feet long.

Looking south at trench at landward toe. (Spring 2015)

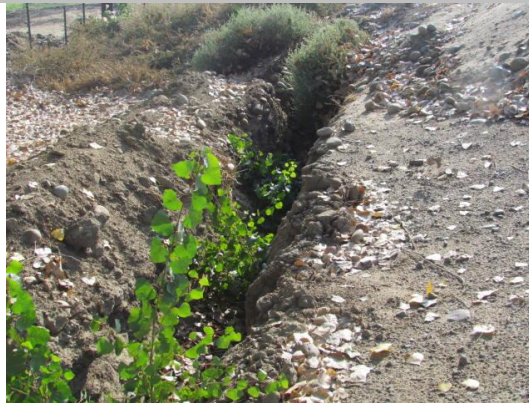
Photo 2 of 3 : SP_2016_NA0010_139_29_20160512_00023.jpg

LM Start	1.53	Rating **	U	Issue No.	29 (cont)
LM End	1.53	Issue Type +	En	Location *	LS

Looking south at trench at landward toe.

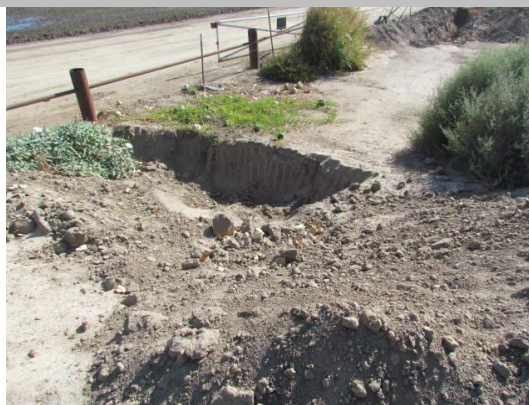
Photo 1 of 3 : SP_2016_NA0010_139_24_20160512_00018.jpg

LM Start	1.54	Rating **	U	Issue No.	24
LM End	1.54	Issue Type +	En	Location *	LS
Category	Earthen Levee			GPS Latitude/Longitude	
				Start	End
Item	Encroachments			36.771922 °	36.771922 °
				-120.259321 °	-120.259321 °
DWR ID	DWR_NA0010_23_f_2015_24				
Comment Code					
DT : Ditch					
Inspector Comment					
Landowner digging at landward berm.

Looking southeast at large pot hole on landward berm.

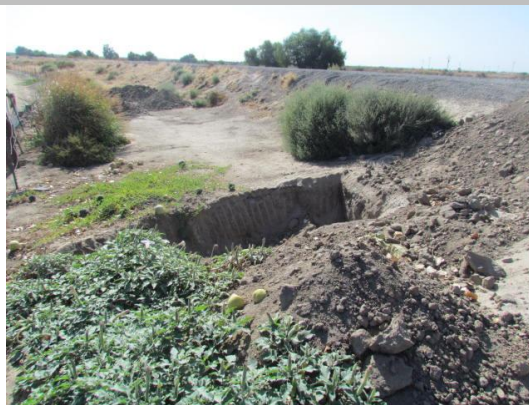
Photo 2 of 3 : SP_2016_NA0010_139_24_20160512_00019.jpg

LM Start	1.54	Rating **	U	Issue No.	24 (cont)
LM End	1.54	Issue Type +	En	Location *	LS

Looking south west at large pot hole on landward berm.

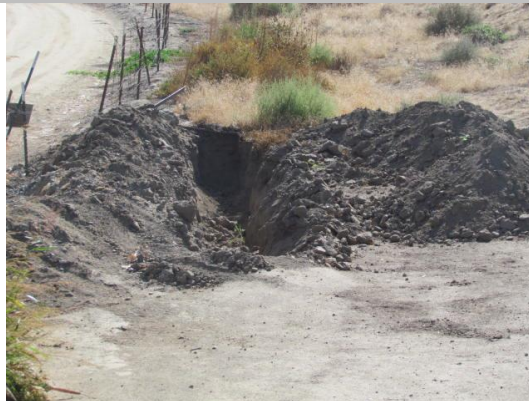
Photo 3 of 3 : SP_2016_NA0010_139_24_20160512_00020.jpg

LM Start	1.54	Rating **	U	Issue No.	24 (cont)	
LM End	1.54	Issue Type +	En	Location *	LS	
Category	Earthen Levee			GPS Latitude/Longitude		
				Start		End
Item	Encroachments			36.771922 °		36.771922 °
				-120.259321 °		-120.259321 °
DWR ID	DWR_NA0010_23_f_2015_24					
Comment Code						
DT : Ditch						
Inspector Comment						
Landowner digging at landward berm.

Looking south at trench on landward berm.

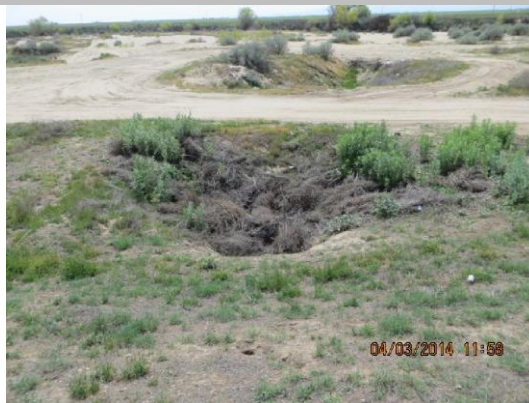
Photo 1 of 2 : UCIP_SP_2016_39538_59855.jpg

LM Start	1.63	Rating **	M	Issue No.	37
LM End	1.63	Issue Type +	En	Location *	LS
Category	Supplemental			GPS Latitude/Longitude	
				Start	End
Item	DWR UCIP Field Study			36.771408 °	36.771408 °
				-120.257899 °	-120.257899 °
DWR ID					
Comment Code					
Inspector Comment					
FS_ID:39538 DS_ID:19948 EP_NO: N/A Repair Type: Non-Urgent Crossing Status: Found UCIP Comments: Appears abandoned and if so should be done properly. Discharge channel is blocked by sand and soil making drain ineffective. Soil buildup at inlet on LS toe. Need to contact owner. FIELD_STRUCT_DESC: 30-inch square R.C.B.C. through the levee, 11.0 feet below the crown. Concrete "U" headwall on the waterward end. Flap gate on the waterward end. Concrete headwall on the landward end. FS Date: 4/3/2014

Concrete headwall on WS toe.
