**Flood Control Project Maintenance
Levee Inspections****LMA District Cover Sheet****Spring 2016 Levee Inspection Results****Lower San Joaquin Levee District**

Spring 2016 Levee Inspection Results

Lower San Joaquin Levee District

Waterway			Bank	Unit Miles
Unit No. 01 San Joaquin River			Right	22.52
	Spring (March - May)	Summer (June - August)	(September - November) Fall	Winter (December - February)
Unit Maintenance Rating (Fall Only)				
Date of Inspection	5/16/2016 - 5/19/2016			
DWR Inspector	Richard Willoughby			
Accompanied By

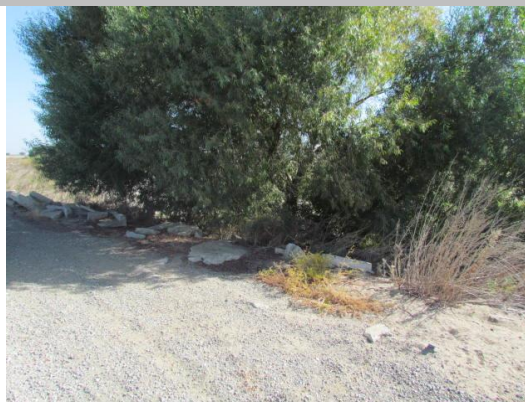
Photo 1 of 1 : SP_2016_NA0010_139_1_20160512_00001.jpg

LM Start	1.91	Rating **	U	Issue No.	1
LM End	1.91	Issue Type +	Ma	Location *	WS
Category	Earthen Levee			GPS Latitude/Longitude	
				Start	End
Item	Trim / Thin Trees			36.772943 °	36.772943 °
				-120.253511 °	-120.253511 °
DWR ID	DWR_NA0010_23_s_2015_1				
Comment Code					
T1 : Trim trees to at least five feet above ground level.					
Inspector Comment					
Untrimmed tree on waterward slope

Looking at untrimmed tree on waterward slope.

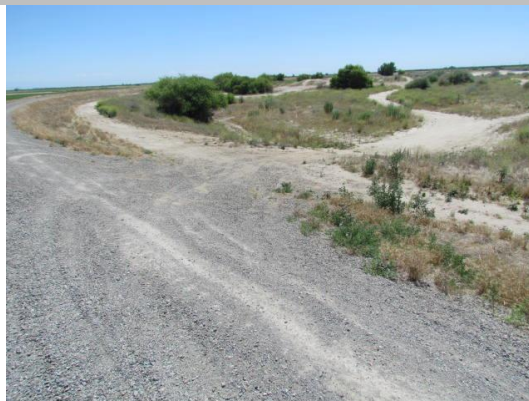
Photo 1 of 1 : SP_2016_NA0010_139_16_20160524_00052.jpg

LM Start	2.12	Rating **	M	Issue No.	16
LM End	2.42	Issue Type +	Ma	Location *	WS
Category	Earthen Levee			GPS Latitude/Longitude	
				Start	End
Item	Slope Stability			36.775507 °	36.774423 °
				-120.251672 °	-120.246993 °
DWR ID	DWR_NA0010_23_s _ 2013_16				
Comment Code					
S3 : Repair the levee slope damaged by vehicle traffic and prevent access where possible.					
Inspector Comment					
Several damaged sites within this reach. Damage caused by vehicle traffic. At. LM. 2.12, 2.21, 2.37, & 2.41

Looking west at one of several slope damaged cause by vehicle traffic.

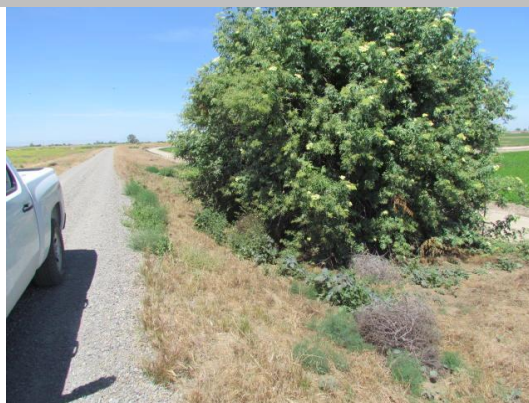
Photo 1 of 3 : SP_2016_NA0010_139_15_20160524_00053.jpg

LM Start	2.85	Rating **	U	Issue No.	15
LM End	2.85	Issue Type +	Ma	Location *	LS
Category	Earthen Levee			GPS Latitude/Longitude	
				Start	End
Item	Vegetation			36.771537 °	36.771537 °
				-120.240917 °	-120.240917 °
DWR ID	DWR_NA0010_23_s _ 2012_15				
Comment Code					
V4 : Elderberries are blocking visibility and flood fight capability.					
Inspector Comment					
Control growth of elderberry bush on landward toe.

Looking north at elderberry at landward toe. (Spring 2016)

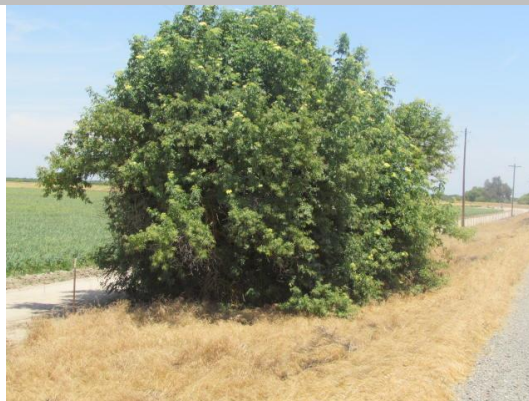
Photo 2 of 3 : SP_2016_NA0010_139_15_20160512_00014.jpg

LM Start	2.85	Rating **	U	Issue No.	15 (cont)
LM End	2.85	Issue Type +	Ma	Location *	LS

Looking south at elderberry at landward toe. (Spring 2015)

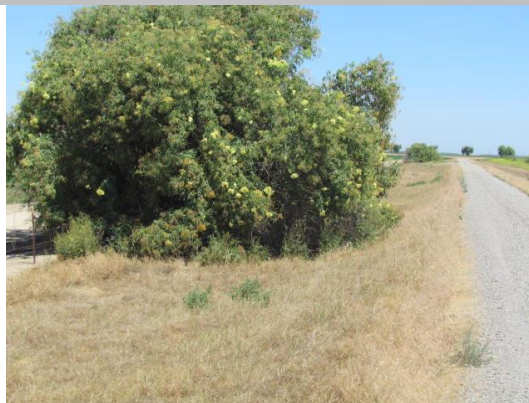
Photo 1 of 4 : SP_2016_NA0010_139_3_20160524_00054.jpg

LM Start	3.30	Rating **	U	Issue No.	3
LM End	3.30	Issue Type +	Ma	Location *	LS
Category	Earthen Levee			GPS Latitude/Longitude	
				Start	End
Item	Vegetation			36.774403 °	36.774403 °
				-120.234705 °	-120.234705 °
DWR ID	DWR_NA0010_23_s _ 2012_3				
Comment Code					
V4 : Elderberries are blocking visibility and flood fight capability.					
Inspector Comment					
Control growth of elderberry on landward toe.

Looking south at elderberry on landward toe and berm. (Spring 2016)

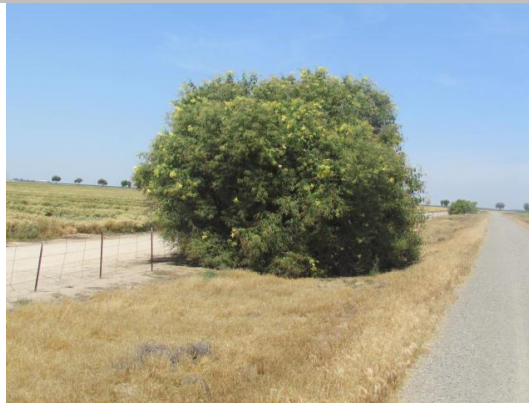
Photo 2 of 4 : SP_2016_NA0010_139_3_20160512_00002.jpg

Looking south at elderberry on landward toe and berm. (Spring 2015)

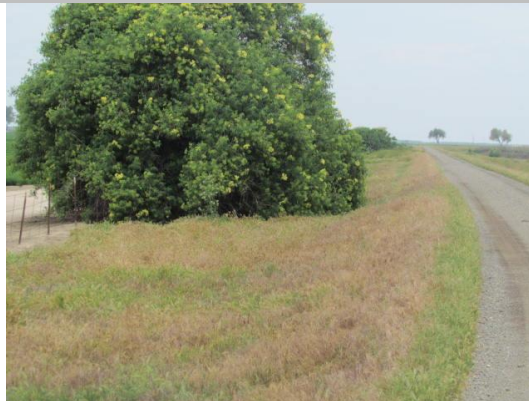
Photo 3 of 4 : SP_2016_NA0010_139_3_20160512_00003.jpg

Looking south at elderberry on landside toe and berm. (Fall 2014)

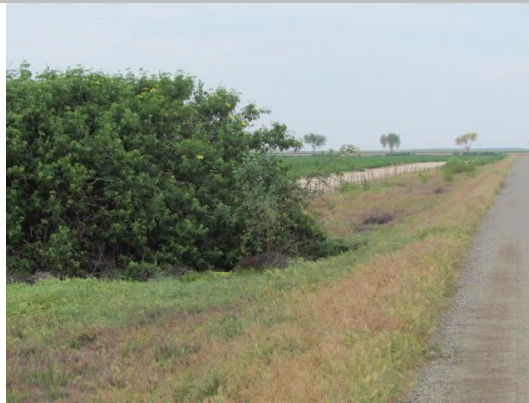
Photo 1 of 1 : SP_2016_NA0010_139_9_20160512_00007.jpg

LM Start	3.45	Rating **	M	Issue No.	9
LM End	3.45	Issue Type +	Ma	Location *	LS
Category	Earthen Levee			GPS Latitude/Longitude	
				Start	End
Item	Vegetation			36.776537 °	36.776537 °
				-120.234573 °	-120.234573 °
DWR ID	DWR_NA0010_23_s _ 2012_9				
Comment Code					
V4 : Elderberries are blocking visibility and flood fight capability.					
Inspector Comment					
Control growth of elderberry on landward toe and berm.

Looking south at elderberry on landside toe and berm.

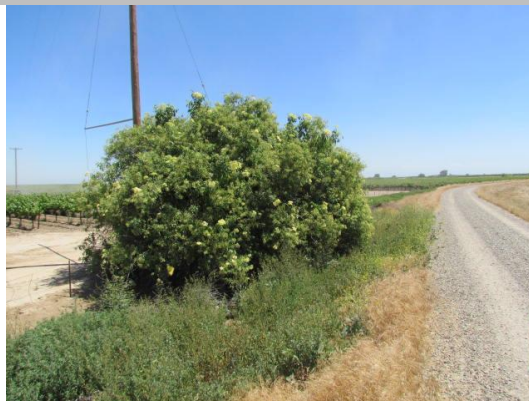
Photo 1 of 3 : SP_2016_NA0010_139_10_20160524_00055.jpg

Looking south at elderberry bush on landward toe. (Spring 2016)

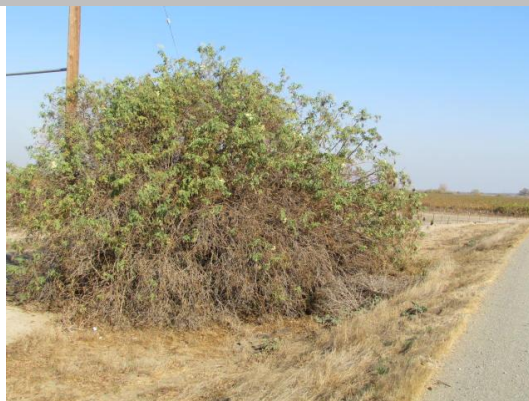
Photo 3 of 3 : SP_2016_NA0010_139_10_20160512_00008.jpg

Looking south at elderberry bush on landward toe. (Fall 2013)

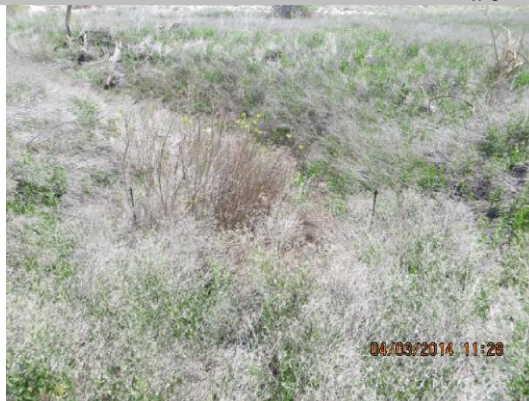
Photo 2 of 2 : UCIP_SP_2016_39540_59847.jpg

LM Start	4.85	Rating **	M	Issue No.	38 (cont)	
LM End	4.85	Issue Type +	En	Location *	LS	
Category	Supplemental			GPS Latitude/Longitude		
				Start		End
Item	DWR UCIP Field Study			36.789550 °		36.789550 °
				-120.220367 °		-120.220367 °
DWR ID						
Comment Code						
Inspector Comment						
FS_ID:39540						
DS_ID:19953						
EP_NO: N/A						
Repair Type: Non-Urgent						
Crossing Status: Found						
UCIP Comments: Heavy vegetation at inlet and outlet--recommend clearing.						
FIELD_STRUCT_DESC: 30-inch square R.C.B.C. through the levee, 10.7 feet below the crown. Concrete "U" headwall on both ends. 4.5'X7' Concrete riser with slide gate on the waterward slope. Inlet channel cobble revetted 15.0 feet long.						
FS Date: 4/3/2014

Heavy vegetation in outlet/channel on WS toe.

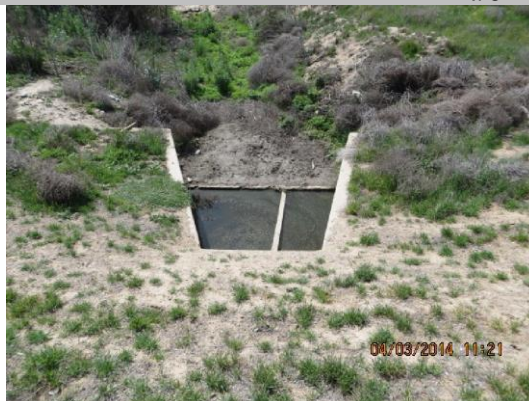
Photo 1 of 2 : UCIP_SP_2016_39542_59830.jpg

Comment Code					
Inspector Comment					
FS_ID:39542 DS_ID:19954 EP_NO: N/A Repair Type: Non-Urgent Crossing Status: Found UCIP Comments: Dense vegetation limits the inspector's visibility to identify signs of pipe failure (leaks) along the landward slope. Recommend removing vegetation along pipe alignment to conduct proper inspection of structure. FIELD_STRUCT_DESC: 36-inch square R.C.B.C through the levee 9.0 feet below the crown. Concrete "U" headwalls on both ends. Flap gate on the waterward end. Outlet channel cobble revetted 5.0 feet long. (USACE-1967). This entry matches the Drainage or Irrigation Structure referenced in O&M manual (HLM 5.71). FS Date: 4/3/2014

Concrete headwall on WS toe.

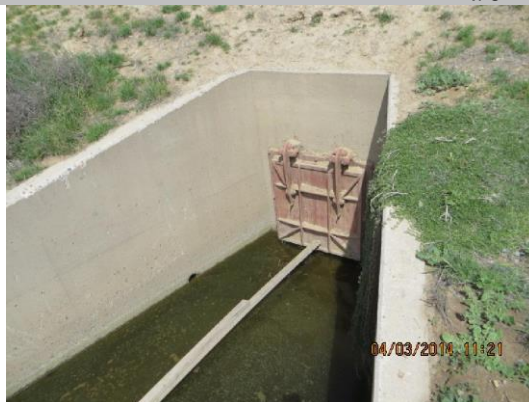
Photo 2 of 2 : UCIP_SP_2016_39542_59829.jpg

Flapgate on Concrete headwall on WS toe.

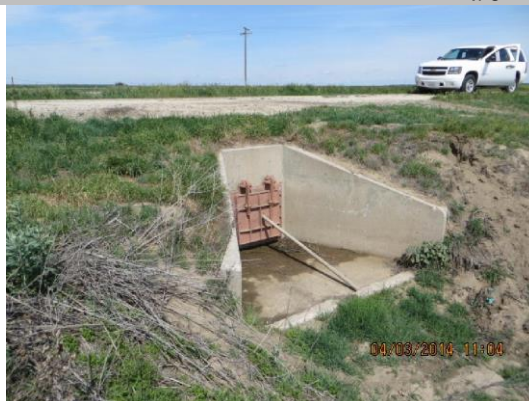
Photo 1 of 2 : UCIP_SP_2016_39544_59823.jpg

Comment Code					
Inspector Comment					
FS_ID:39544					
DS_ID:19940					
EP_NO: N/A					
Repair Type: Non-Urgent					
Crossing Status: Found					
UCIP Comments: Some sediment buildup at inlet at LS toe. Also dense vegetation limits the inspector's visibility to identify signs of pipe failure (leaks) along the landward slope. Recommend removing vegetation along pipe alignment to conduct proper inspection of structure.					
FIELD_STRUCT_DESC: 30-inch square R.C.B.C. through the levee, 5.2 feet below the crown. Concrete "U" headwall on the waterward end. Flap gate on the waterward end. Concrete headwalls on the landward end. (USACE-1967). This entry matches the Drainage or Irrigation Structure referenced in O&M manual (HLM 8.33).					
FS Date: 4/3/2014

Flapgate on WS toe.

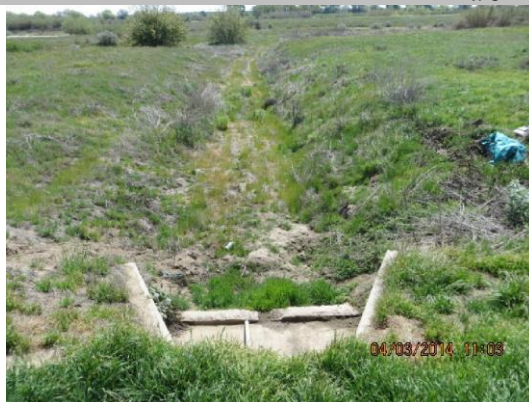
Photo 2 of 2 : UCIP_SP_2016_39544_59821.jpg

concrete headwall at drainage ditch on WS toe.

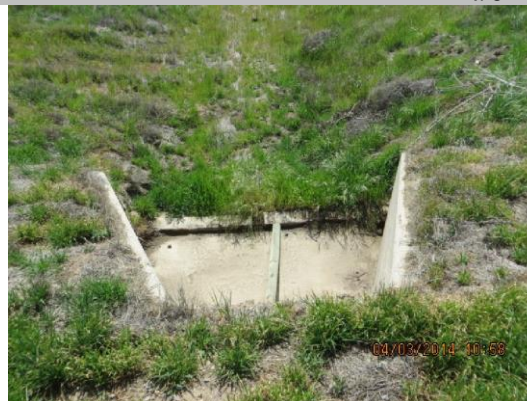
Photo 1 of 2 : UCIP_SP_2016_39545_59817.jpg

Comment Code					
Inspector Comment					
FS_ID:39545 DS_ID:19941 EP_NO: N/A Repair Type: Non-Urgent Crossing Status: Found UCIP Comments: Dense vegetation limits the inspector's visibility to identify signs of pipe failure (leaks) along the landward slope. Recommend removing vegetation along pipe alignment to conduct proper inspection of structure. FIELD_STRUCT_DESC: 30-inch square R.C.B.C. through the levee, 5.6 feet below the crown. Concrete "U" headwall on the waterward end. Flap gate on the waterward end. Concrete headwall on the landward end. (USACE-1967). This entry matches the Drainage or Irrigation Structure referenced in O&M manual (HLM 8.54). FS Date: 4/3/2014

Concrete headwall on WS toe.

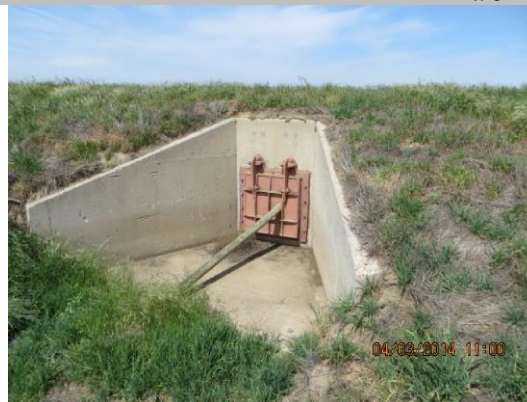
Photo 2 of 2 : UCIP_SP_2016_39545_59819.jpg

Flapgate on Concrete headwall at WS toe.

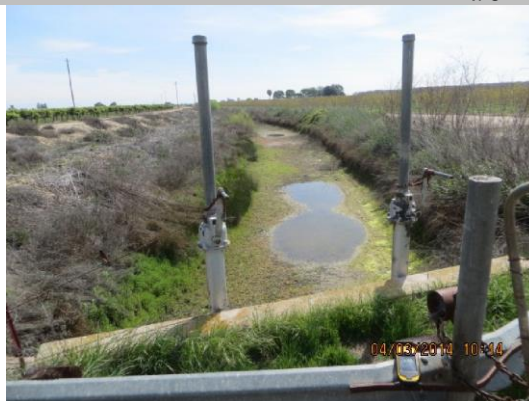
Photo 1 of 2 : UCIP_SP_2016_33066_59810.jpg

FS_ID:33066
DS_ID:19943
EP_NO: N/A
Repair Type: Urgent
Crossing Status: Found
UCIP Comments: Slide gate not functional. Slide gate channels heavily corroded (exfoliated) and likely impact functionality/structural integrity of gate.
FIELD_STRUCT_DESC: 1 of 2: 5.25 x 4 foot R.C.B.C. through the levee, 10.0 feet below the crown. Concrete "U" headwall on the waterward end. Gear pedestal slide gate with wall bracket on the waterward headwall. Concrete "U" headwall on the landward end. Outlet channel cobble revetted 10.0 feet long. Guard rails on both shoulders. Slide gates on waterward side. (USACE-1967). This entry matches the Drainage or Irrigation Structure referenced in O&M manual (HLM 9.76). [Gravelly Ford Canal Irrigation Structure]
FS Date: 4/3/2014

Slide gate actuator visible on WS shoulder with concrete headwall.

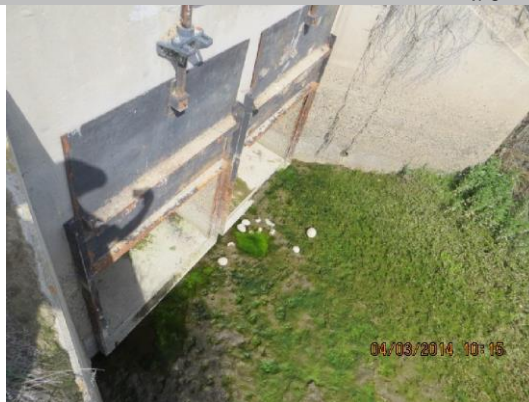
Photo 2 of 2 : UCIP_SP_2016_33063_59801.jpg

Comment Code					
Inspector Comment					
FS_ID:33063					
DS_ID:19980					
EP_NO: N/A					
Repair Type: Urgent					
Crossing Status: Found					
UCIP Comments: Slide gate not functional. Slide gate channels heavily corroded (exfoliated) and likely impact functionality/structural integrity of gate.					
FIELD_STRUCT_DESC: 2 of 2: 48x63-inch R.C.B.C. through the levee, 10.0 feet below the crown. Concrete "U" headwall on the waterward end. Gear pedestal slide gate with wall bracket on the waterward headwall. Concrete "U" headwall on the landward end. Outlet channel cobble revetted 10.0 feet long. Guardrails on both shoulders. [Gravelly Ford Canal Irrigation Structure]					
FS Date: 4/3/2014

Slide gates on WS toe.

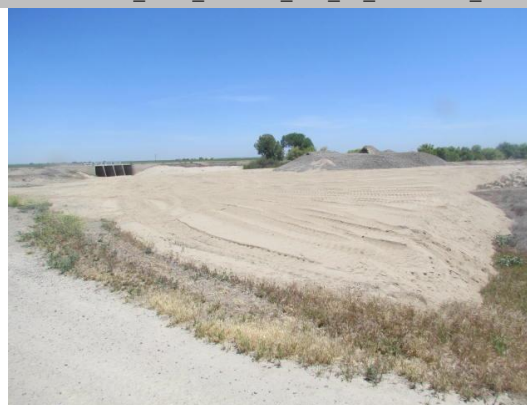
Photo 1 of 2 : SP_2016_NA0010_140_47_20160512_00010.jpg

LM Start	0.06	Rating **	M	Issue No.	47
LM End	0.06	Issue Type +	En	Location *	LS
Category	Earthen Levee			GPS Latitude/Longitude	
				Start	End
Item	Encroachments			36.772328 °	36.772328 °
				-120.285117 °	-120.285117 °
DWR ID	DWR_NA0010_24_s _ 2014_47				
Comment Code					
MA : Material					
Inspector Comment					
District constructed a berm on waterward slope. Berm is being used for staging of earthen material.

Looking south at berm on waterward slope.

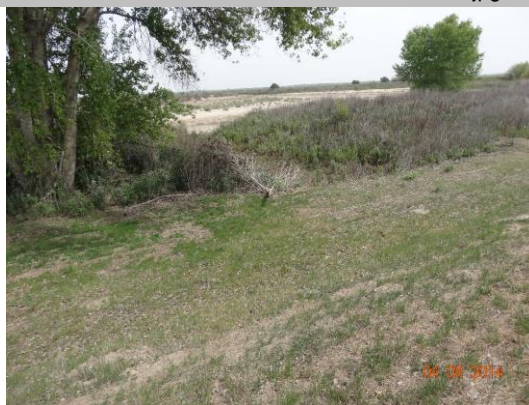
Photo 1 of 2 : UCIP_SP_2016_33264_60059.jpg

LM Start	0.50	Rating **	M	Issue No.	268
LM End	0.50	Issue Type +	En	Location *	LS
Category	Supplemental			GPS Latitude/Longitude	
				Start	End
Item	DWR UCIP Field Study			36.766872 °	36.766872 °
				-120.283212 °	-120.283212 °
DWR ID					
Comment Code					
Inspector Comment					
FS_ID:33264 DS_ID:19955 EP_NO: N/A Repair Type: Non-Urgent Crossing Status: Found UCIP Comments: No access available to confirm condition of landward side headwall. Recommend clearing debris along fence. Surface erosion near concrete headwall on landward side was present. FIELD_STRUCT_DESC: 30-inch square R.C.B.C. through the levee, 13.5 feet below the crown. Concrete headwalls on both ends. Flap gate on the waterward end. FS Date: 4/8/2014

View of waterward side.

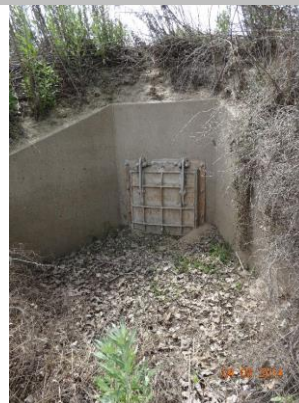
Photo 2 of 2 : UCIP_SP_2016_33264_60057.jpg

LM Start	0.50	Rating **	M	Issue No.	268 (cont)	
LM End	0.50	Issue Type +	En	Location *	LS	
Category	Supplemental			GPS Latitude/Longitude		
				Start	End	
Item	DWR UCIP Field Study			36.766872 °	36.766872 °	
				-120.283212 °	-120.283212 °	
DWR ID						
Comment Code						
Inspector Comment						
FS_ID:33264						
DS_ID:19955						
EP_NO: N/A						
Repair Type: Non-Urgent						
Crossing Status: Found						
UCIP Comments: No access available to confirm condition of landward side headwall. Recommend clearing debris along fence. Surface erosion near concrete headwall on landward side was present.						
FIELD_STRUCT_DESC: 30-inch square R.C.B.C. through the levee, 13.5 feet below the crown. Concrete headwalls on both ends. Flap gate on the waterward end.						
FS Date: 4/8/2014

Square gate visible on waterward side.

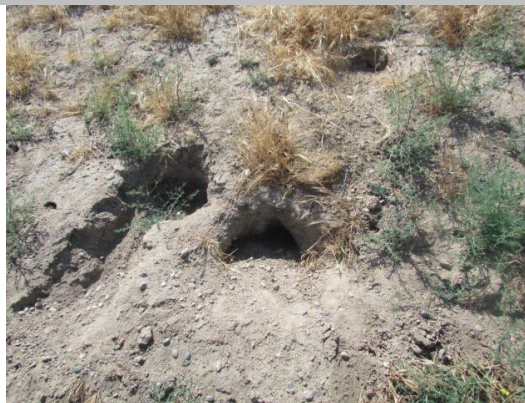
Photo 1 of 1 : SP_2016_NA0010_140_6_20160512_00005.jpg

LM Start	0.82	Rating **	M	Issue No.	6
LM End	0.82	Issue Type +	Ma	Location *	LS
Category	Earthen Levee			GPS Latitude/Longitude	
				Start	End
Item	Animal Control			36.766775 °	36.766775 °
				-120.278757 °	-120.278757 °
DWR ID	DWR_NA0010_24_s_2013_6				
Comment Code					
A1 : Exterminate rodents and backfill and compact or grout burrows.					
Inspector Comment					
Noted several rodent holes within this section.

Looking at several rodent holes on landward slope.

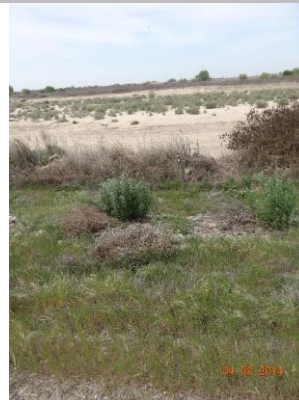
Photo 2 of 2 : UCIP_SP_2016_33265_60064.jpg

View of waterward side.

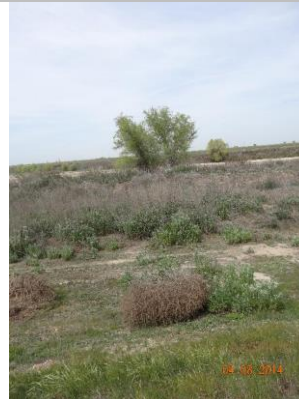
Photo 2 of 2 : UCIP_SP_2016_33266_60070.jpg

View of waterward side.

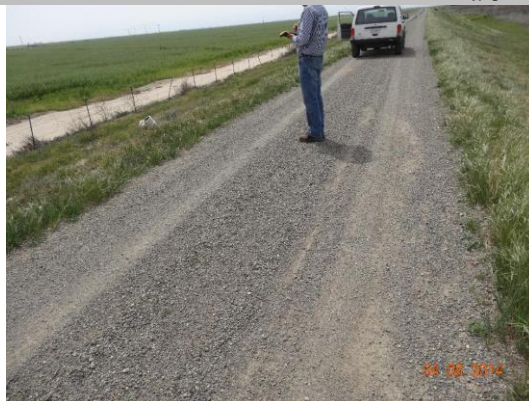
Photo 1 of 2 : UCIP_SP_2016_33267_60075.jpg

LM Start	2.69	Rating **	M	Issue No.	271
LM End	2.69	Issue Type +	En	Location *	LS
Category	Supplemental			GPS Latitude/Longitude	
				Start	End
Item	DWR UCIP Field Study			36.771742 °	36.771742 °
				-120.250929 °	-120.250929 °
DWR ID					
Comment Code					
Inspector Comment					
FS_ID:33267 DS_ID:19963 EP_NO: 13735 Repair Type: Non-Urgent Crossing Status: Found UCIP Comments: Unable to confirm status of crossing. FIELD_STRUCT_DESC: 24-inch steel discharge pipe through the levee, 2-feet below the crown. Roadway on crown has been padded 1- foot. Siphon breaker on the apex of pipeline on landward shoulder. Galvanized siphon vent pipe on the landward shoulder. Steel cutoff wall around the pipeline at centerline of levee. Pump on landward side. (Permit No. 13735-1984). FS Date: 4/8/2014

Overview of levee crown at crossing.

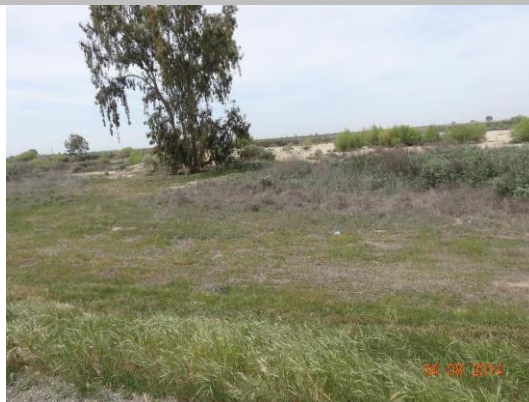
Photo 2 of 2 : UCIP_SP_2016_33267_60076.jpg

View of waterward side.

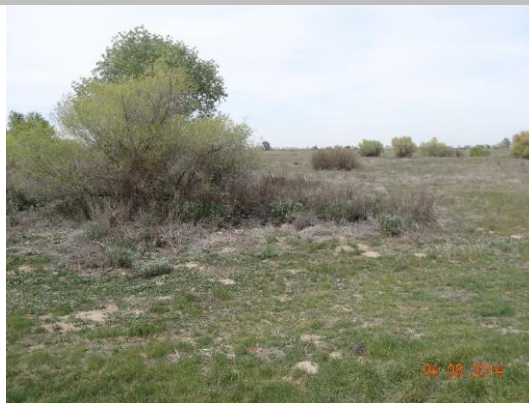
Photo 1 of 2 : UCIP_SP_2016_36849_67237.jpg

LM Start	4.06	Rating **	M	Issue No.	267
LM End	4.06	Issue Type +	En	Location *	LS
Category	Supplemental			GPS Latitude/Longitude	
				Start	End
Item	DWR UCIP Field Study			36.769238 °	36.769238 °
				-120.228588 °	-120.228588 °
DWR ID					
Comment Code					
Inspector Comment					
FS_ID:36849					
DS_ID:19964					
EP_NO: N/A					
Repair Type: Non-Urgent					
Crossing Status: Found					
UCIP Comments: Unable to confirm crossing alignment and appurtenances associated with this crossing. Multiple stand pipes visible on landward side. Need to contact owner to determine status of crossing and alignment.					
FIELD_STRUCT_DESC: 30-inch square R.C.B.C. through the levee 12.5 feet below the crown. Concrete riser unit with slide gate on the waterward slope. Screw gate on landward shoulder. Pump on landward side. Rehabilitation of crossing under Permit No. 13085 (1981).					
FS Date: 4/8/2014

View of waterwar side.

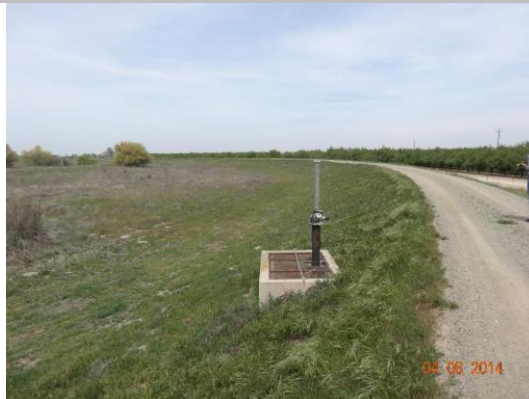
Photo 2 of 2 : UCIP_SP_2016_36849_67236.jpg

Slide gate inside concrete box located on waterward side.

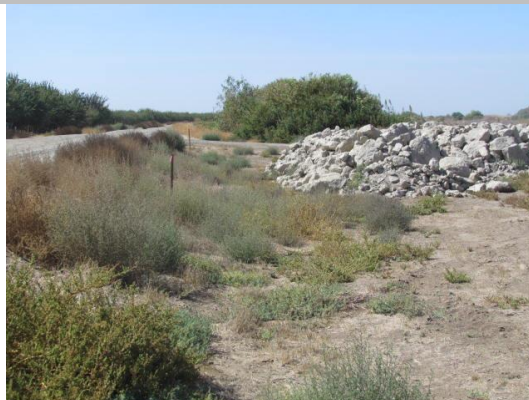
Photo 1 of 2 : SP_2016_NA0010_140_266_20160512_00012.jpg

LM Start	5.40	Rating **	M	Issue No.	266
LM End	5.40	Issue Type +	En	Location *	WS
Category	Earthen Levee			GPS Latitude/Longitude	
				Start	End
Item	Encroachments			36.782405 °	36.782405 °
				-120.222763 °	-120.222763 °
DWR ID	DWR_NA0010_24_s_2015_266				
Comment Code					
MA : Material					
Inspector Comment					
Rocks stockpile near waterward toe.

Looking at rock stockpile on waterward berm. Fall 2015

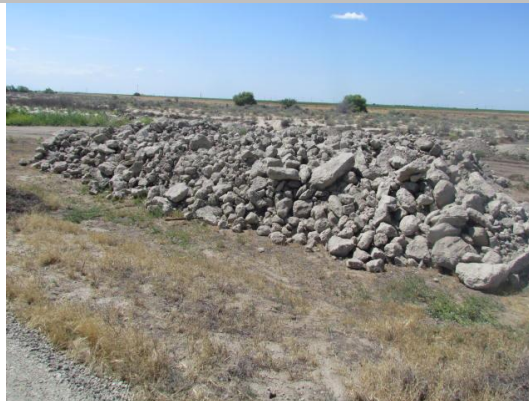
Photo 2 of 2 : SP_2016_NA0010_140_266_20160512_00013.jpg

Looking north at rock pile on waterward berm.

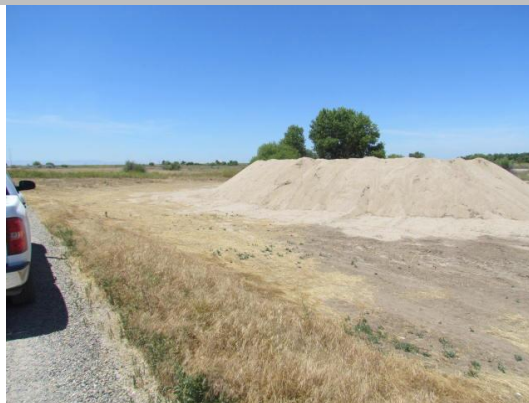
Photo 1 of 1 : SP_2016_NA0010_140_2_20160524_00035.jpg

LM Start	6.15	Rating **	U	Issue No.	2
LM End	6.15	Issue Type +	En	Location *	WS
Category	Earthen Levee			GPS Latitude/Longitude	
				Start	End
Item	Encroachments			36.788088 °	36.788088 °
				-120.212827 °	-120.212827 °
DWR ID	DWR_NA0010_24_s _ 2016_2				
Comment Code					
MA : Material					
Inspector Comment					
Sandpile on waterward berm over three feet high and 25 feet away from waterward toe should removed.

Looking northeast at sandpile over three on waterward berm.

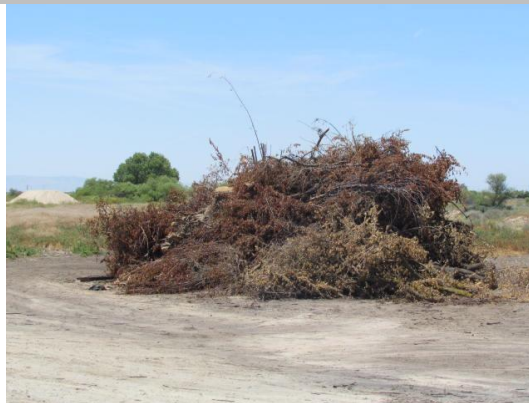
Photo 1 of 1 : SP_2016_NA0010_140_3_20160524_00036.jpg

LM Start	6.33	Rating **	U	Issue No.	3
LM End	6.33	Issue Type +	Ma	Location *	WS
Category	Earthen Levee			GPS Latitude/Longitude	
				Start	End
Item	Encroachments			36.788155 °	36.788155 °
				-120.209655 °	-120.209655 °
DWR ID	DWR_NA0010_24_s_2012_3				
Comment Code					
PR : Prunings					
Inspector Comment					
Large pruning pile in channel.

Looking east at pruning pile on waterward berm.

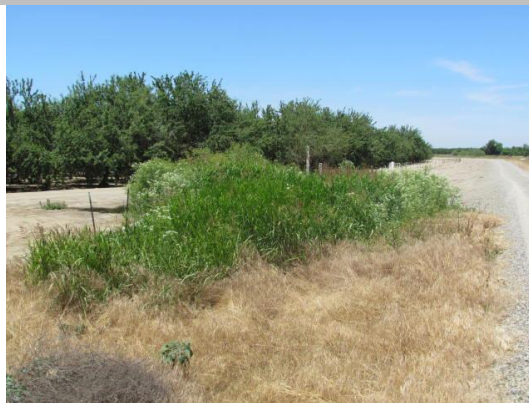
Photo 1 of 1 : SP_2016_NA0010_140_15_20160524_00037.jpg

LM Start	6.72	Rating **	U	Issue No.	15
LM End	6.91	Issue Type +	Ma	Location *	LS
Category	Earthen Levee			GPS Latitude/Longitude	
				Start	End
Item	Vegetation			36.786678 °	36.783993 °
				-120.204741 °	-120.203779 °
DWR ID	DWR_NA0010_24_f_2015_15				
Comment Code					
V2 : Remove the wild growth other than native grasses from the levee slopes.					
Inspector Comment					
Dense vegetation on landward slope

Looking northwest at dense veg on landward slope and toe.

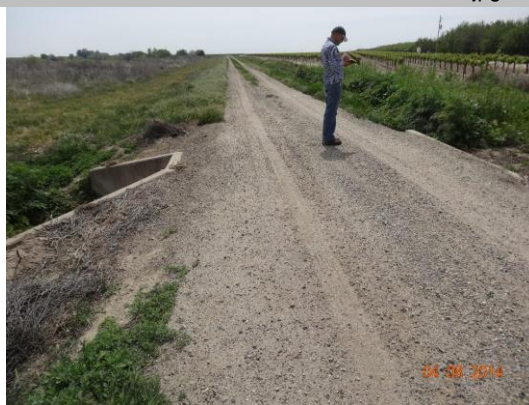
Photo 1 of 2 : UCIP_SP_2016_42933_60105.jpg

LM Start	6.73	Rating **	U	Issue No.	273
LM End	6.73	Issue Type +	En	Location *	LS
Category	Supplemental			GPS Latitude/Longitude	
				Start	End
Item	DWR UCIP Field Study			36.786632 °	36.786632 °
				-120.204733 °	-120.204733 °
DWR ID					
Comment Code					
Inspector Comment					
FS_ID:42933 DS_ID:19957 EP_NO: N/A Repair Type: Urgent Crossing Status: Found UCIP Comments: Unauthorized PVC pipe through existng crossing. PVC distorted inside--Need to contact owner to correct issue. If crossing was allowed need to contact owner for permit number issue for crossing variance. FIELD_STRUCT_DESC: 24-inch CM pipe through the levee, 3.6 feet below the crown. Concrete "U" headwall on the waterward end. Flap gate on the waterward end. Concrete headwall on the landward end. FS Date: 4/8/2014

Overview of levee crown at crossing.

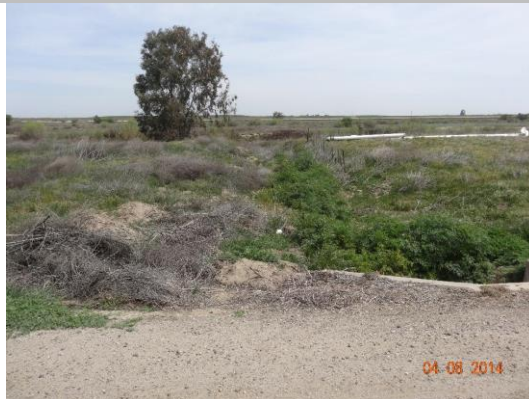
Photo 2 of 2 : UCIP_SP_2016_42933_60107.jpg

View of waterward side--debris (pipe sections) located on waterward

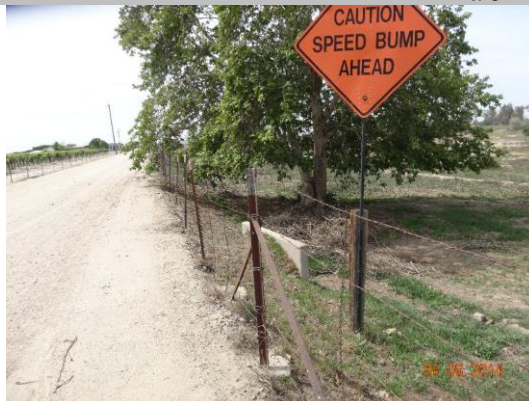
Photo 1 of 2 : UCIP_SP_2016_33272_60121.jpg

LM Start	8.33	Rating **	M	Issue No.	272
LM End	8.33	Issue Type +	En	Location *	CR
Category	Supplemental			GPS Latitude/Longitude	
				Start	End
Item	DWR UCIP Field Study			36.778084 °	36.778084 °
				-120.184454 °	-120.184454 °
DWR ID					
Comment Code					
Inspector Comment					
FS_ID:33272					
DS_ID:19960					
EP_NO: N/A					
Repair Type: Non-Urgent					
Crossing Status: Found					
UCIP Comments: Barbed wire along levee shoulder--no access. Need to confirm crossing size and condition of crossing.					
FIELD_STRUCT_DESC: 12-inch concrete pipe through the levee, 3.0 feet below the crown. Concrete headwall on the waterward end. Flap gate on the waterward end. (USACE-1967). This entry matches the Drainage or Irrigation Structure referenced in O&M manual (HLM 8.32).					
FS Date: 4/8/2014

View of waterward side.

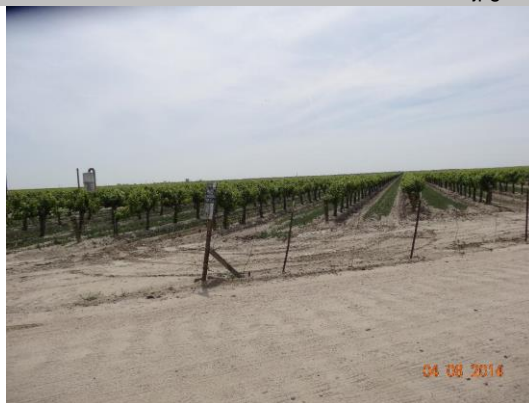
Photo 2 of 2 : UCIP_SP_2016_33272_60120.jpg

View of landward side.

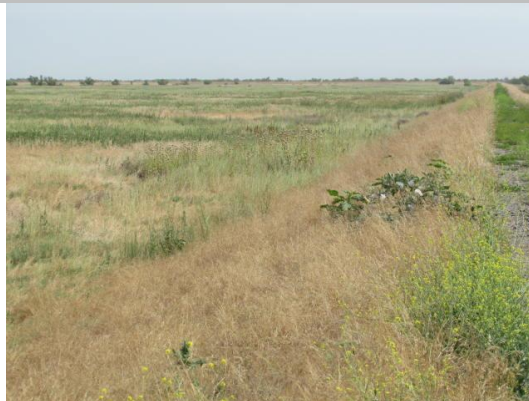
Photo 1 of 1 : SP_2016_NA0010_141_7_20160524_00022.jpg

LM Start	0.00	Rating **	U	Issue No.	7
LM End	2.48	Issue Type +	Ma	Location *	LS
Category	Earthen Levee			GPS Latitude/Longitude	
				Start	End
Item	Vegetation			37.296261 °	37.271165 °
				-120.880678 °	-120.866629 °
DWR ID	DWR_NA0010_25_f_2015_7				
Comment Code					
V2 : Remove the wild growth other than native grasses from the levee slopes.					
Inspector Comment

Looking at typical view of landward slope.

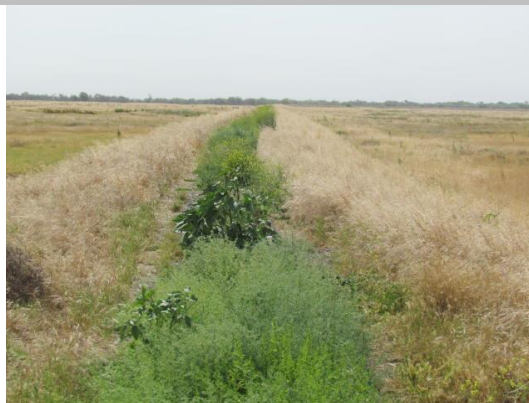
Photo 1 of 1 : SP_2016_NA0010_141_9_20160524_00023.jpg

LM Start	0.00	Rating **	U	Issue No.	9
LM End	2.49	Issue Type +	Ma	Location *	WS
Category	Earthen Levee			GPS Latitude/Longitude	
				Start	End
Item	Vegetation			37.296261 °	37.271117 °
				-120.880678 °	-120.866599 °
DWR ID	DWR_NA0010_25_f_2015_9				
Comment Code					
V2 : Remove the wild growth other than native grasses from the levee slopes.					
Inspector Comment

Looking at typical view of waterward slope.

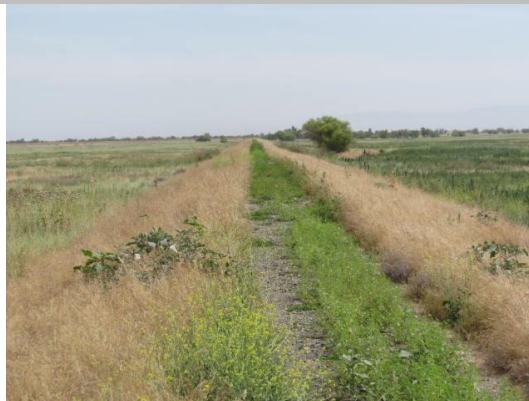
Photo 1 of 1 : SP_2016_NA0010_141_8_20160524_00024.jpg

LM Start	0.01	Rating **	U	Issue No.	8
LM End	2.49	Issue Type +	Ma	Location *	CR
Category	Earthen Levee			GPS Latitude/Longitude	
				Start	End
Item	Vegetation			37.296117 °	37.271117 °
				-120.880724 °	-120.866599 °
DWR ID	DWR_NA0010_25_s_2012_8				
Comment Code					
V2 : Remove the wild growth other than native grasses from the levee slopes.					
Inspector Comment					
Control weeds on levee crown.

Looking at typical view of levee crown.

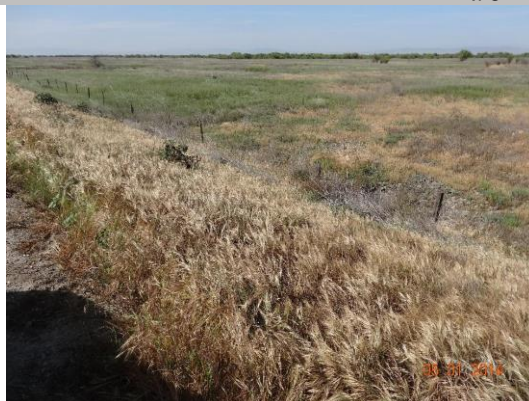
Photo 1 of 2 : UCIP_SP_2016_39501_67242.jpg

LM Start	0.02	Rating **	M	Issue No.	14
LM End	0.02	Issue Type +	En	Location *	CR
Category	Supplemental			GPS Latitude/Longitude	
				Start	End
Item	DWR UCIP Field Study			37.296038 °	37.296038 °
				-120.880742 °	-120.880742 °
DWR ID					
Comment Code					
Inspector Comment					
FS_ID:39501 DS_ID:19965 EP_NO: N/A Repair Type: Non-Urgent Crossing Status: Found UCIP Comments: Dense vegetation limits the inspectors visibility to identify signs of pipe failure (leaks) along the slope. Recommend removing vegetation along pipe alignment to conduct proper inspection of structure. Sediment buildup in pipe visible from landward side--recommend clearing. FIELD_STRUCT_DESC: 24-inch CM pipe through the levee, 10.0 feet below the crown. Flap gate on the waterward end. (USACE-1967). This entry matches the Drainage or Irrigation Structure referenced in O&M manual (HLM 0.02). FS Date: 5/1/2014

View of waterward side--dense vegetation on waterward side.

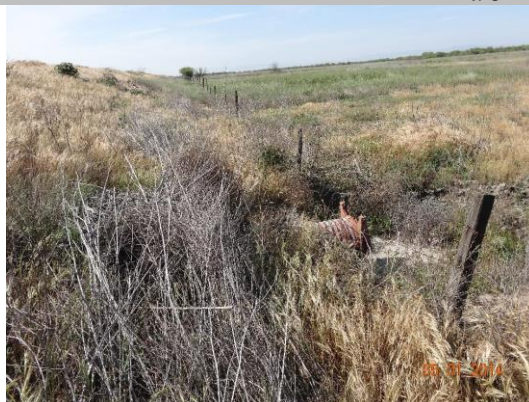
Photo 2 of 2 : UCIP_SP_2016_39501_67240.jpg

Pipe daylight visible on waterward toe.

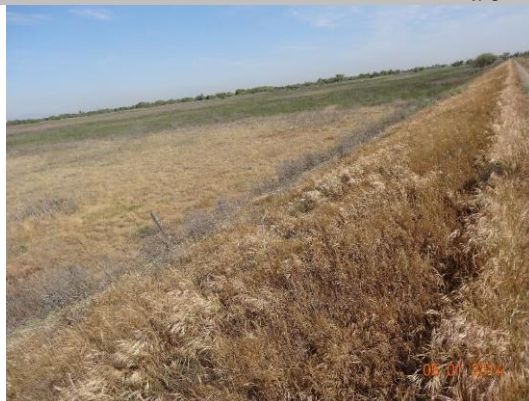
Photo 1 of 2 : UCIP_SP_2016_36851_67249.jpg

LM Start	0.36	Rating **	M	Issue No.	10
LM End	0.36	Issue Type +	En	Location *	CR
Category	Supplemental			GPS Latitude/Longitude	
				Start	End
Item	DWR UCIP Field Study			37.291173 °	37.291173 °
				-120.880731 °	-120.880731 °
DWR ID					
Comment Code					
Inspector Comment					
FS_ID:36851					
DS_ID:19966					
EP_NO: N/A					
Repair Type: Non-Urgent					
Crossing Status: Found					
UCIP Comments: Dense vegetation limits the inspectors visibility to identify signs of pipe failure (leaks) along the slope. Recommend removing vegetation along pipe alignment to conduct proper inspection of structure.					
FIELD_STRUCT_DESC: 24-inch CM pipe through the levee, 11.6 feet below the crown. Flap gate on the waterward end. (USACE-1967). This entry matches the Drainage or Irrigation Structure referenced in O&M manual (HLM 0.35).					
FS Date: 5/1/2014

View of waterward side.

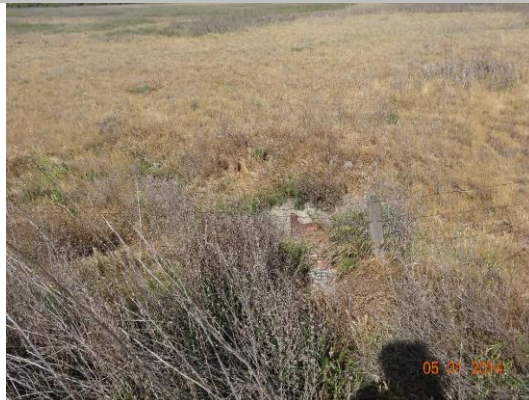
Photo 2 of 2 : UCIP_SP_2016_36851_67248.jpg

Pipe outlet visible on waterward side.

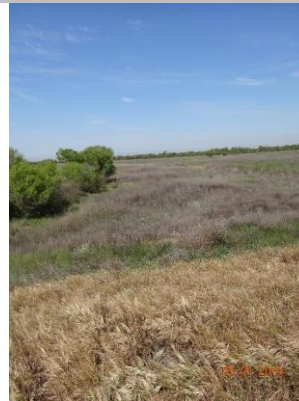
Photo 1 of 2 : UCIP_SP_2016_36852_67250.jpg

LM Start	0.59	Rating **	M	Issue No.	11
LM End	0.59	Issue Type +	En	Location *	CR
Category	Supplemental			GPS Latitude/Longitude	
				Start	End
Item	DWR UCIP Field Study			37.287744 °	37.287744 °
				-120.880645 °	-120.880645 °
DWR ID					
Comment Code					
Inspector Comment					
FS_ID:36852					
DS_ID:19967					
EP_NO: N/A					
Repair Type: Non-Urgent					
Crossing Status: Found					
UCIP Comments: Dense vegetation limits the inspectors visibility to identify signs of pipe failure (leaks) along the slope. Recommend removing vegetation along pipe alignment to conduct proper inspection of structure.					
FIELD_STRUCT_DESC: 24-inch CM pipe through the levee, 14.7 feet below the crown. Flap gate on the waterward end. (USACE-1967). This entry matches the Drainage or Irrigation Structure referenced in O&M manual (HLM 0.59).					
FS Date: 5/1/2014

Overview of waterward side--Salt Slough.

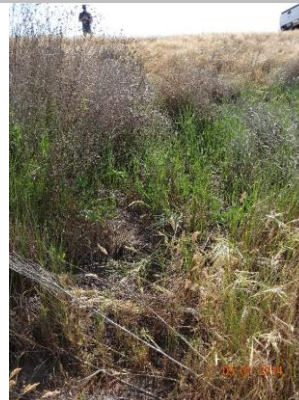
Photo 2 of 2 : UCIP_SP_2016_36852_67251.jpg

View of waterward slope covered by dense vegetation.

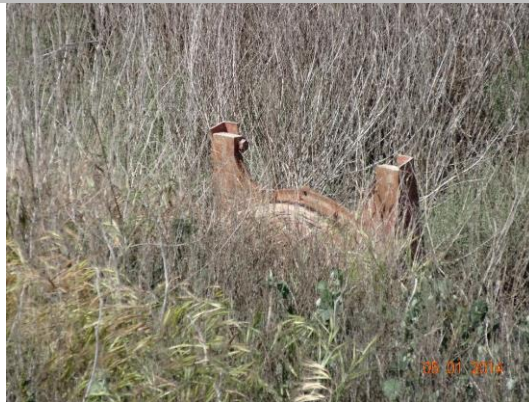
Photo 2 of 2 : UCIP_SP_2016_36853_67255.jpg

Pipe and evidence of flap gate visible on waterward side.

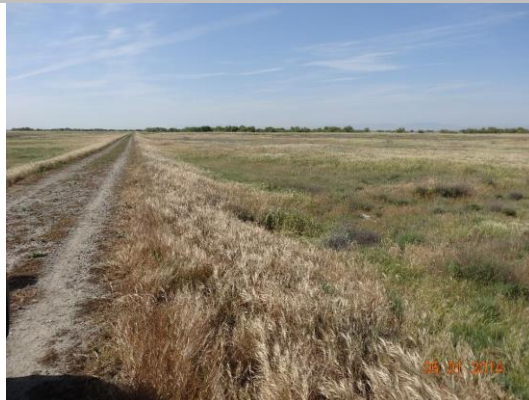
Photo 2 of 2 : UCIP_SP_2016_36854_67260.jpg

View of waterward side.

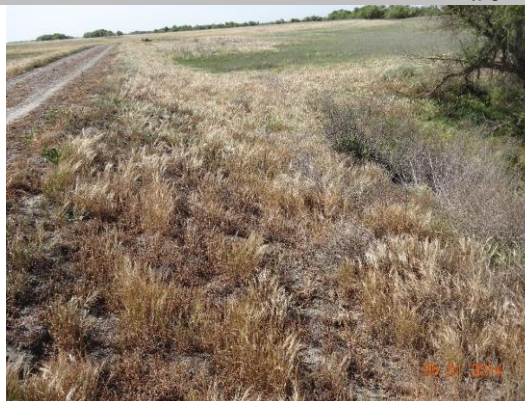
Photo 1 of 2 : UCIP_SP_2016_39502_67270.jpg

FS_ID:39502
DS_ID:19970
EP_NO: N/A
Repair Type: Non-Urgent
Crossing Status: Found
UCIP Comments: Dense vegetation limits the inspectors visibility to identify signs of pipe failure (leaks) along the slope. Recommend removing vegetation along pipe alignment to conduct proper inspection of structure. Sediment buildup in pipe visible on landward side--recommend clearing.
FIELD_STRUCT_DESC: 24-inch CM pipe through the levee, 11.2 feet below the crown. Flap gate on the waterward end. (USACE-1967). This entry matches the Drainage or Irrigation Structure referenced in O&M manual (HLM 2.45).
FS Date: 5/1/2014 4:04:00 PM

View of waterward side.

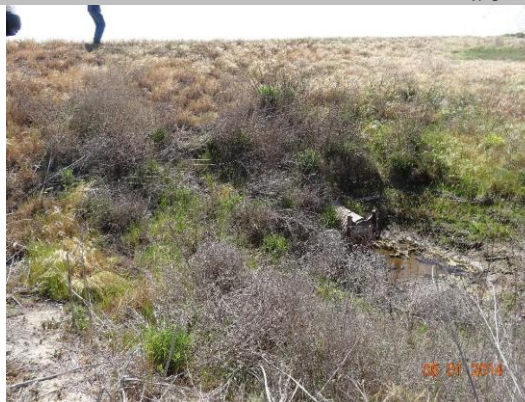
Photo 2 of 2 : UCIP_SP_2016_39502_67269.jpg

Pipe daylights at waterward toe.
