**Flood Control Project Maintenance  
Levee Inspections**  
**LMA District Cover Sheet**  
**Spring 2017 Levee Inspection Results**

**Lower San Joaquin Levee District**

Waterway			Bank	Unit Miles
Unit No. 01 San Joaquin River			Right	22.52
	Spring (March - May)	Summer (June - August)	(September - November) Fall	Winter (December - February)
Unit Maintenance Rating (Fall Only)				
Date of Inspection	4/17/2017 - 4/20/2017			
DWR Inspector	Richard Willoughby			
Accompanied By

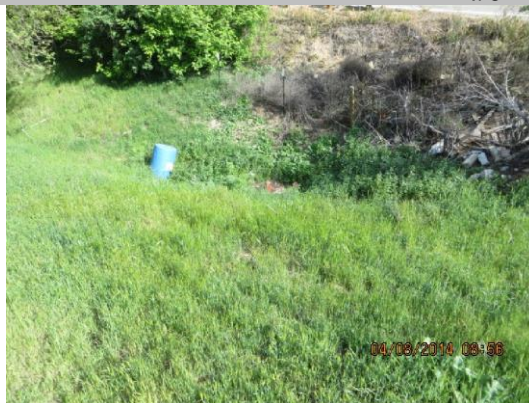
Photo 1 of 3 : UCIP\_SP\_2017\_39091\_60601.jpg

Comment Code					
Inspector Comment					
FS_ID:39091 DS_ID:19650 EP_NO: N/A Repair Type: Non-Urgent Crossing Status: Found UCIP Comments: Dense vegetation limits the inspector's visibility to identify signs of pipe failure (leaks) along the waterward slope and landward toe. Recommend removing vegetation along pipe alignment and landward toe to conduct proper inspection of structure and appurtenances. FIELD_STRUCT_DESC: 24-inch CM stormdrain pipe through the levee, 10.5 feet below the crown. Flap gate on the waterward end. Brass cap No. 108 BM on headwall on the landward side. (USACE-1967). This entry matches the Drainage or Irrigation Structure referenced in O&M manual (HLM 0.02). FS Date: 4/8/2014 7:34:00 AM

Flapgate on WS toe.

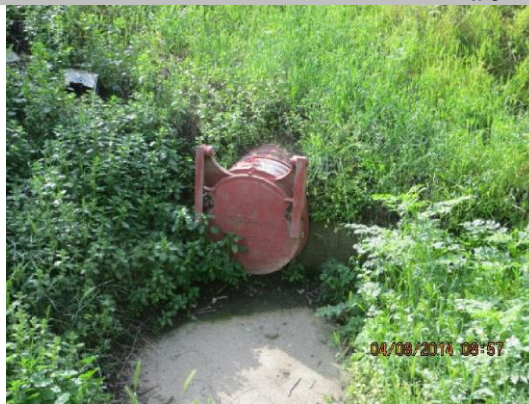
Photo 2 of 3 : UCIP\_SP\_2017\_39091\_60600.jpg

Flapgate on WS toe.

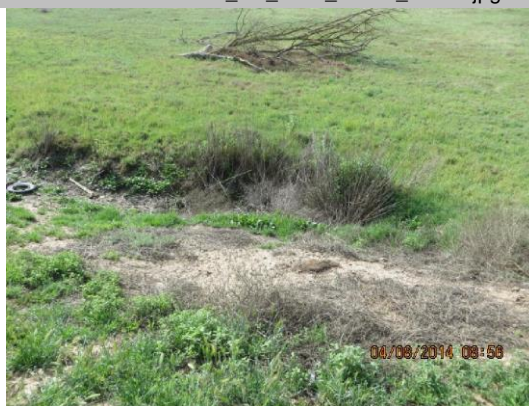
Photo 3 of 3 : UCIP\_SP\_2017\_39091\_60602.jpg

Comment Code					
Inspector Comment					
FS_ID:39091 DS_ID:19650 EP_NO: N/A Repair Type: Non-Urgent Crossing Status: Found UCIP Comments: Dense vegetation limits the inspector's visibility to identify signs of pipe failure (leaks) along the waterward slope and landward toe. Recommend removing vegetation along pipe alignment and landward toe to conduct proper inspection of structure and appurtenances. FIELD_STRUCT_DESC: 24-inch CM stormdrain pipe through the levee, 10.5 feet below the crown. Flap gate on the waterward end. Brass cap No. 108 BM on headwall on the landward side. (USACE-1967). This entry matches the Drainage or Irrigation Structure referenced in O&M manual (HLM 0.02). FS Date: 4/8/2014 7:34:00 AM

Headwall on LS toe.

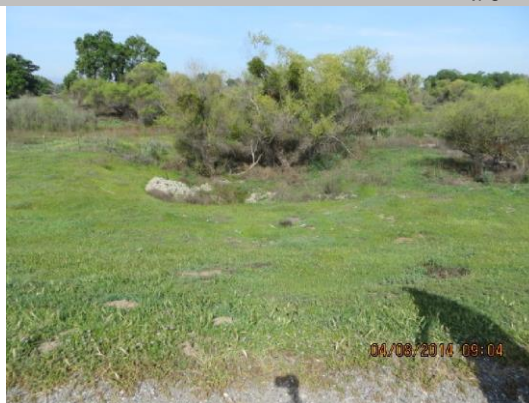
Photo 1 of 3 : UCIP\_SP\_2017\_39092\_60611.jpg

LM Start	0.34	Rating **	M	Issue No.	1186
LM End	0.34	Issue Type +	Ma	Location *	LS
Category	Supplemental			GPS Latitude/Longitude	
				Start	End
Item	DWR UCIP LMA Responsibility			37.344705 °	37.344705 °
				-120.962176 °	-120.962176 °
DWR ID					
Comment Code					
Inspector Comment					
FS_ID:39092 DS_ID:19651 EP_NO: N/A Repair Type: Non-Urgent Crossing Status: Found UCIP Comments: Pipe has significant sediment buildup and shows some signs of corrosion at landward toe. Recommend cleaning sediment from inside pipe and check wall integrity. FIELD_STRUCT_DESC: 36-inch CM stormdrain pipe through the levee, 18.5 feet below the crown. Flap gate on the waterward end. Brass cap No. 108 BM on headwall on the landward side. (USACE-1967). This entry matches the Drainage or Irrigation Structure referenced in O&M manual (HLM 0.35). FS Date: 4/8/2014

Flapgate and headwall visible off WS toe.

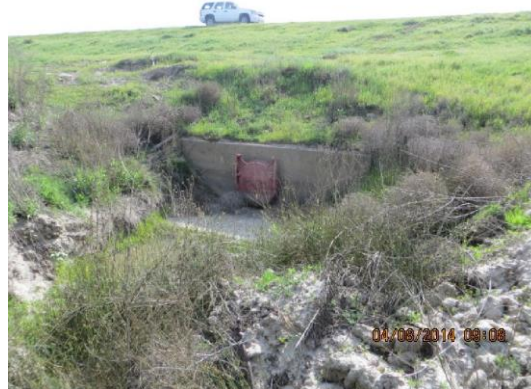
Photo 2 of 3 : UCIP\_SP\_2017\_39092\_60613.jpg

Item	DWR UCIP LMA Responsibility			37.344705 °	37.344705 °	
				-120.962176 °	-120.962176 °	
DWR ID						
Comment Code						
Inspector Comment						
FS_ID:39092						
DS_ID:19651						
EP_NO: N/A						
Repair Type: Non-Urgent						
Crossing Status: Found						
UCIP Comments: Pipe has significant sediment buildup and shows some signs of corrosion at landward toe. Recommend cleaning sediment from inside pipe and check wall integrity.						
FIELD_STRUCT_DESC: 36-inch CM stormdrain pipe through the levee, 18.5 feet below the crown. Flap gate on the waterward end. Brass cap No. 108 BM on headwall on the landward side. (USACE-1967). This entry matches the Drainage or Irrigation Structure referenced in O&M manual (HLM 0.35).						
FS Date: 4/8/2014

Flapgate and headwall visible off WS toe.

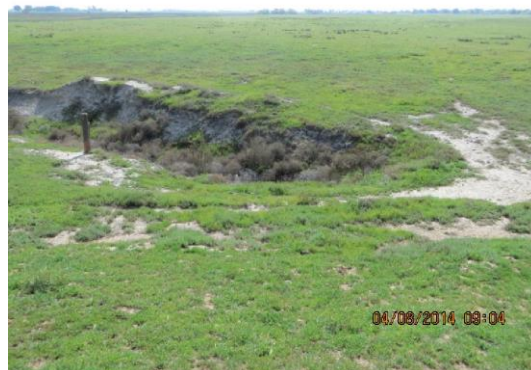
Photo 3 of 3 : UCIP\_SP\_2017\_39092\_60612.jpg

Pipe and headwall visible off LS toe.

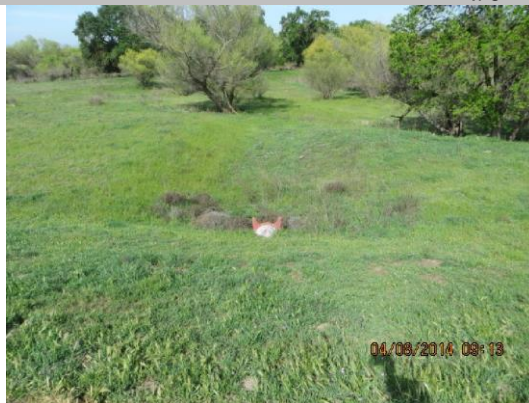
Photo 1 of 3 : UCIP\_SP\_2017\_39095\_60622.jpg

LM Start	0.60	Rating **	M	Issue No.	1187
LM End	0.60	Issue Type +	Ma	Location *	LS
Category	Supplemental			GPS Latitude/Longitude	
				Start	End
Item	DWR UCIP LMA Responsibility			37.341507 °	37.341507 °
				-120.961283 °	-120.961283 °
DWR ID					
Comment Code					
Inspector Comment					
FS_ID:39095 DS_ID:19583 EP_NO: N/A Repair Type: Non-Urgent Crossing Status: Found UCIP Comments: Recommend removing vegetation pile from waterward toe. FIELD_STRUCT_DESC: 24-inch CM stormdrain pipe through the levee, 8.5 feet below the crown. Flap gate on the waterward end. Brass cap No. 108 BM on headwall on the landward side. (USACE-1967). This entry matches the Drainage or Irrigation Structure referenced in O&M manual (HLM 0.62). FS Date: 4/8/2014

Flapgate and headwall visible on WS toe.

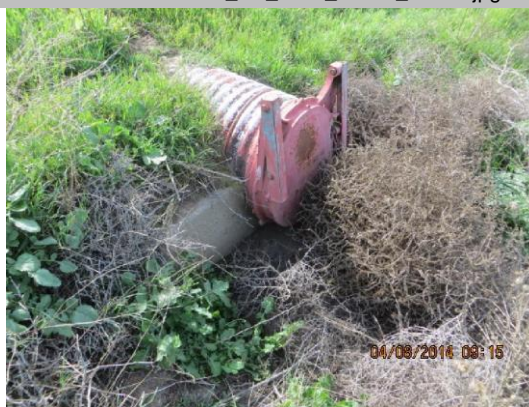
Photo 2 of 3 : UCIP\_SP\_2017\_39095\_60623.jpg

Flapgate and headwall visible on WS toe.

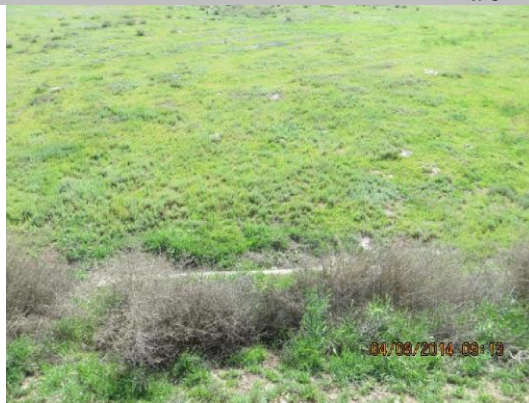
Photo 3 of 3 : UCIP\_SP\_2017\_39095\_60621.jpg

LM Start	0.60	Rating **	M	Issue No.	1187 (cont)
LM End	0.60	Issue Type +	Ma	Location *	LS
Category	Supplemental			GPS Latitude/Longitude	
				Start	End
Item	DWR UCIP LMA Responsibility			37.341507 °	37.341507 °
				-120.961283 °	-120.961283 °
DWR ID					
Comment Code					
Inspector Comment					
FS_ID:39095 DS_ID:19583 EP_NO: N/A Repair Type: Non-Urgent Crossing Status: Found UCIP Comments: Recommend removing vegetation pile from waterward toe. FIELD_STRUCT_DESC: 24-inch CM stormdrain pipe through the levee, 8.5 feet below the crown. Flap gate on the waterward end. Brass cap No. 108 BM on headwall on the landward side. (USACE-1967). This entry matches the Drainage or Irrigation Structure referenced in O&M manual (HLM 0.62). FS Date: 4/8/2014

Pipe and headwall visible on LS toe.

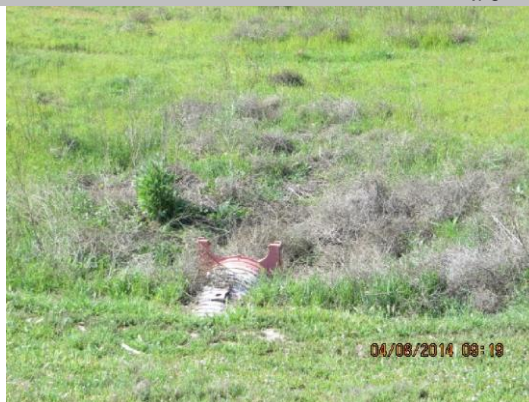
Photo 1 of 3 : UCIP\_SP\_2017\_33524\_60627.jpg

LM Start	0.85	Rating **	A/W	Issue No.	1188
LM End	0.85	Issue Type +	Ma	Location *	LS
Category	Supplemental			GPS Latitude/Longitude	
				Start	End
Item	DWR UCIP LMA Responsibility			37.339829 °	37.339829 °
				-120.958621 °	-120.958621 °
DWR ID					
Comment Code					
Inspector Comment					
FS_ID:33524					
DS_ID:19584					
EP_NO: N/A					
Repair Type: No Action Needed					
Crossing Status: Found					
UCIP Comments:					
FIELD_STRUCT_DESC: 24-inch CM pipe through the levee, 7-feet below the crown. Flap gate on the waterward end. Brass cap No. 108 BM on headwall on the landward side. (USACE-1967). This entry matches the Drainage or Irrigation Structure referenced in O&M manual (HLM 0.87).					
FS Date: 4/8/2014

Pipe, flapgate, and headwall visible on WS toe.

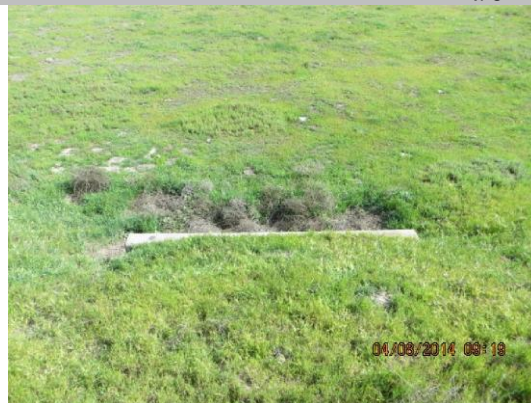
Photo 2 of 3 : UCIP\_SP\_2017\_33524\_60626.jpg

LM Start	0.85	Rating **	A/W	Issue No.	1188 (cont)	
LM End	0.85	Issue Type +	Ma	Location *	LS	
Category	Supplemental			GPS Latitude/Longitude		
				Start		End
Item	DWR UCIP LMA Responsibility			37.339829 °		37.339829 °
				-120.958621 °		-120.958621 °
DWR ID						
Comment Code						
Inspector Comment						
FS_ID:33524						
DS_ID:19584						
EP_NO: N/A						
Repair Type: No Action Needed						
Crossing Status: Found						
UCIP Comments:						
FIELD_STRUCT_DESC: 24-inch CM pipe through the levee, 7-feet below the crown. Flap gate on the waterward end. Brass cap No. 108 BM on headwall on the landward side. (USACE-1967). This entry matches the Drainage or Irrigation Structure referenced in O&M manual (HLM 0.87).						
FS Date: 4/8/2014

Pipe and headwall visible on LS toe.

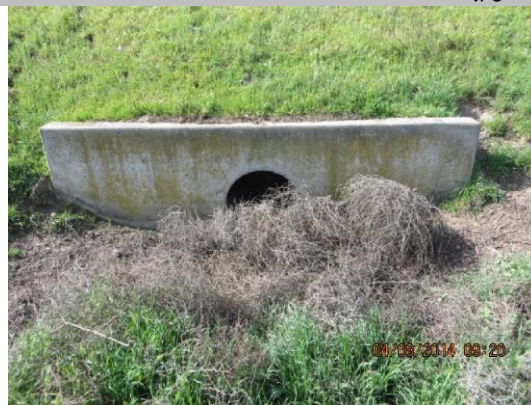
Photo 3 of 3 : UCIP\_SP\_2017\_33524\_60625.jpg

Pipe and headwall visible on LS toe.

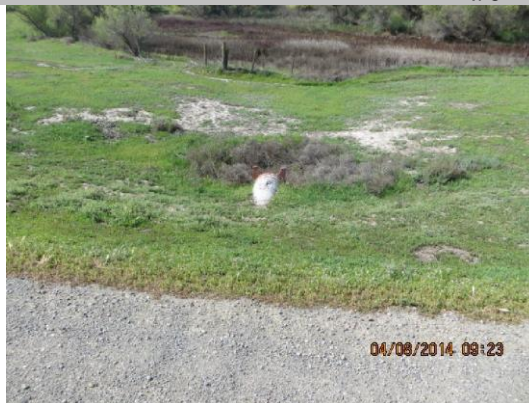
Photo 1 of 3 : UCIP\_SP\_2017\_39096\_60632.jpg

LM Start	0.93	Rating **	M	Issue No.	1189
LM End	0.93	Issue Type +	Ma	Location *	LS
Category	Supplemental			GPS Latitude/Longitude	
				Start	End
Item	DWR UCIP LMA Responsibility			37.339598 °	37.339598 °
				-120.957202 °	-120.957202 °
DWR ID					
Comment Code					
Inspector Comment					
FS_ID:39096 DS_ID:19585 EP_NO: N/A Repair Type: Non-Urgent Crossing Status: Found UCIP Comments: Moderate erosion around headwall on landward toe. May or may not be an issue. Need to contact owner to determine status of crossing and to address erosion issue on landward side. FIELD_STRUCT_DESC: 24-inch CM pipe through the levee, 7-feet below the crown. Flap gate on the waterward end. Brass cap No. 108 BM on headwall on the landward side. (USACE-1967). This entry matches the Drainage or Irrigation Structure referenced in O&M manual (HLM 0.95). FS Date: 4/8/2014

Flapgate, pipe, and headwall on WS toe.

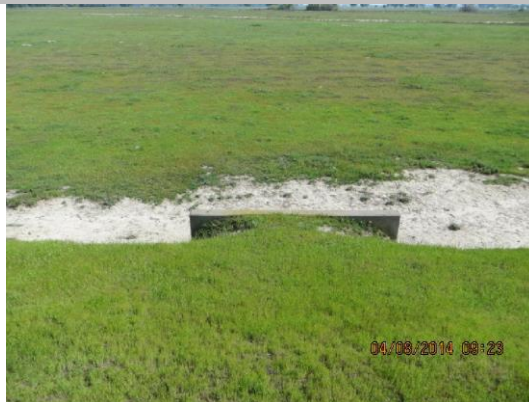
Photo 2 of 3 : UCIP\_SP\_2017\_39096\_60631.jpg

Concrete headwall and pipe visible at LS toe.

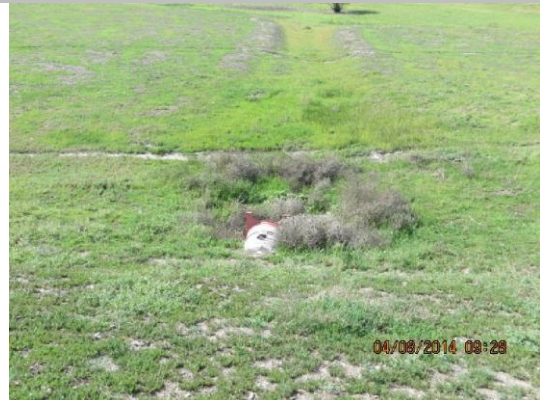
Photo 1 of 3 : UCIP\_SP\_2017\_33543\_60642.jpg

LM Start	1.15	Rating **	A/W	Issue No.	1190
LM End	1.15	Issue Type +	Ma	Location *	LS
Category	Supplemental			GPS Latitude/Longitude	
				Start	End
Item	DWR UCIP LMA Responsibility			37.338005 °	37.338005 °
				-120.953921 °	-120.953921 °
DWR ID					
Comment Code					
Inspector Comment					
FS_ID:33543 DS_ID:19586 EP_NO: N/A Repair Type: No Action Needed Crossing Status: Found UCIP Comments: FIELD_STRUCT_DESC: 24-inch CM stormdrain pipe through the levee, 7.5 feet below the crown. Flap gate on the waterward end. Brass cap No. 108 BM on headwall on the landward side. (USACE-1967). This entry matches the Drainage or Irrigation Structure referenced in O&M manual (HLM 1.17). FS Date: 4/8/2014

Pipe, headwall, and flapgate visible on WS toe.

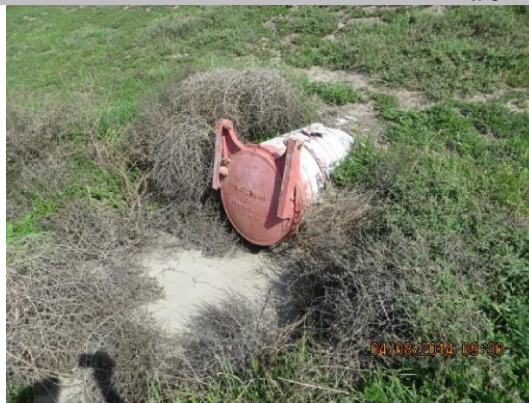
Photo 2 of 3 : UCIP\_SP\_2017\_33543\_60643.jpg

LM Start	1.15	Rating **	A/W	Issue No.	1190 (cont)	
LM End	1.15	Issue Type +	Ma	Location *	LS	
Category	Supplemental			GPS Latitude/Longitude		
				Start	End	
Item	DWR UCIP LMA Responsibility			37.338005 °	37.338005 °	
				-120.953921 °	-120.953921 °	
DWR ID						
Comment Code						
Inspector Comment						
FS_ID:33543						
DS_ID:19586						
EP_NO: N/A						
Repair Type: No Action Needed						
Crossing Status: Found						
UCIP Comments:						
FIELD_STRUCT_DESC: 24-inch CM stormdrain pipe through the levee, 7.5 feet below the crown. Flap gate on the waterward end. Brass cap No. 108 BM on headwall on the landward side. (USACE-1967). This entry matches the Drainage or Irrigation Structure referenced in O&M manual (HLM 1.17).						
FS Date: 4/8/2014

Pipe, headwall, and flapgate visible on WS toe.

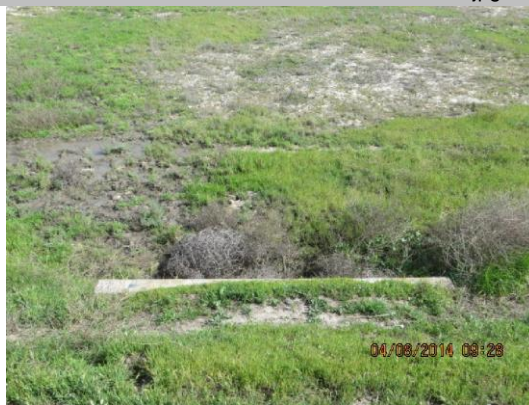
Photo 3 of 3 : UCIP\_SP\_2017\_33543\_60641.jpg

Headwall and pipe visible on LS toe.

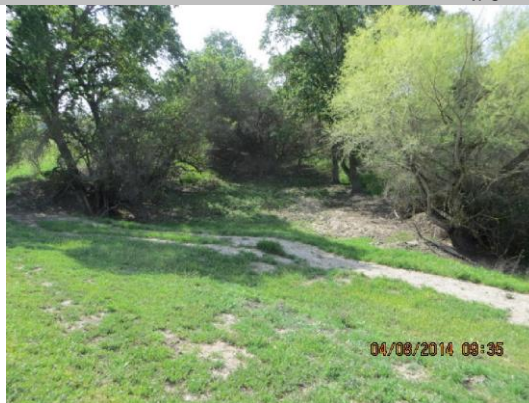
Photo 1 of 3 : UCIP\_SP\_2017\_33544\_60649.jpg

LM Start	1.32	Rating **	A/W	Issue No.	1191
LM End	1.32	Issue Type +	Ma	Location *	LS
Category	Supplemental			GPS Latitude/Longitude	
				Start	End
Item	DWR UCIP LMA Responsibility			37.337361 °	37.337361 °
				-120.950879 °	-120.950879 °
DWR ID					
Comment Code					
Inspector Comment					
FS_ID:33544 DS_ID:19587 EP_NO: N/A Repair Type: No Action Needed Crossing Status: Found UCIP Comments: FIELD_STRUCT_DESC: 36-inch CM stormdrain pipe through the levee, 12.8 feet below the crown. Flap gate on the waterward end. Brass cap No. 108 BM on headwall on the landward side. (USACE-1967). This entry matches the Drainage or Irrigation Structure referenced in O&M manual (HLM 1.34). Pipe crosses through levee at about a 45 degree angle to crown. FS Date: 4/8/2014

Concrete headwall and flapgate visible at WS toe.

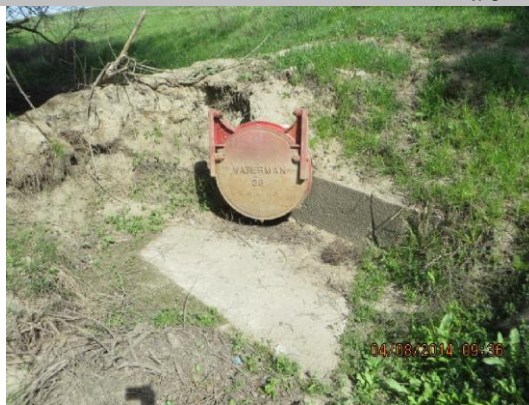
Photo 2 of 3 : UCIP\_SP\_2017\_33544\_60648.jpg

Concrete headwall and flapgate visible at WS toe.

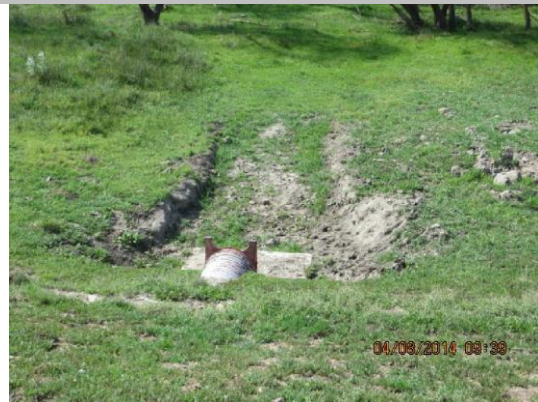
Photo 1 of 3 : UCIP\_SP\_2017\_39099\_60652.jpg

LM Start	1.46	Rating **	M	Issue No.	1192
LM End	1.46	Issue Type +	Ma	Location *	LS
Category	Supplemental			GPS Latitude/Longitude	
				Start	End
Item	DWR UCIP LMA Responsibility			37.336866 °	37.336866 °
				-120.948520 °	-120.948520 °
DWR ID					
Comment Code					
Inspector Comment					
FS_ID:39099					
DS_ID:19588					
EP_NO: N/A					
Repair Type: Non-Urgent					
Crossing Status: Found					
UCIP Comments: Some sediment buildup inside pipe at LS toe.					
Recommend contacting owner to clear sediment buildup and check wall integrity through pipe section.					
FIELD_STRUCT_DESC: 24-inch CM stormdrain pipe through the levee, 11.0 feet below the crown. Flap gate on the waterward end. Brass cap No. 108 BM on headwall on the landward side. (USACE-1967). This entry matches the Drainage or Irrigation Structure referenced in O&M manual (HLM 1.48).					
FS Date: 4/8/2014

Pipe, flapgate, and concrete headwall visible on WS toe.

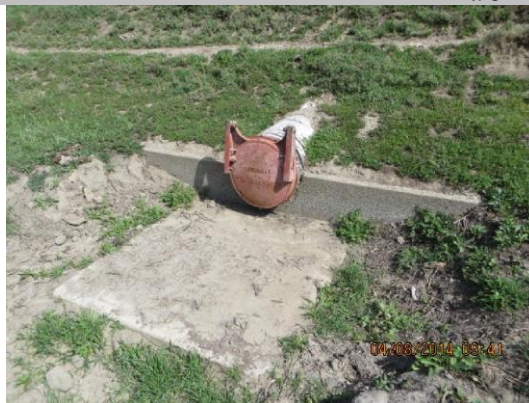
Photo 2 of 3 : UCIP\_SP\_2017\_39099\_60653.jpg

LM Start	1.46	Rating **	M	Issue No.	1192 (cont)
LM End	1.46	Issue Type +	Ma	Location *	LS
Category	Supplemental			GPS Latitude/Longitude	
				Start	End
Item	DWR UCIP LMA Responsibility			37.336866 °	37.336866 °
				-120.948520 °	-120.948520 °
DWR ID					
Comment Code					
Inspector Comment					
FS_ID:39099					
DS_ID:19588					
EP_NO: N/A					
Repair Type: Non-Urgent					
Crossing Status: Found					
UCIP Comments: Some sediment buildup inside pipe at LS toe.					
Recommend contacting owner to clear sediment buildup and check wall integrity through pipe section.					
FIELD_STRUCT_DESC: 24-inch CM stormdrain pipe through the levee, 11.0 feet below the crown. Flap gate on the waterward end. Brass cap No. 108 BM on headwall on the landward side. (USACE-1967). This entry matches the Drainage or Irrigation Structure referenced in O&M manual (HLM 1.48).					
FS Date: 4/8/2014

Pipe, flapgate, and concrete headwall visible on WS toe.

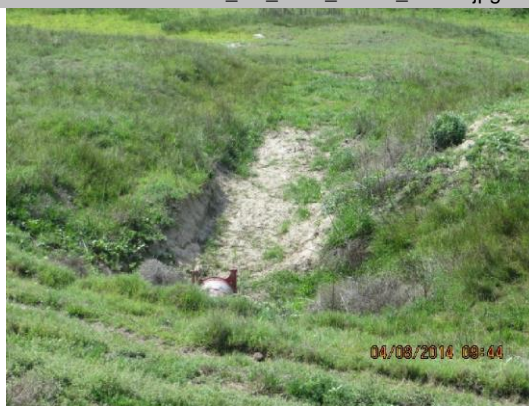
Photo 1 of 3 : UCIP\_SP\_2017\_33563\_60661.jpg

LM Start	1.67	Rating **	M	Issue No.	1193
LM End	1.67	Issue Type +	Ma	Location *	LS
Category	Supplemental			GPS Latitude/Longitude	
				Start	End
Item	DWR UCIP LMA Responsibility			37.336459 °	37.336459 °
				-120.944803 °	-120.944803 °
DWR ID					
Comment Code					
Inspector Comment					
FS_ID:33563					
DS_ID:19589					
EP_NO: N/A					
Repair Type: Non-Urgent					
Crossing Status: Found					
UCIP Comments: Heavy sediment buildup in pipe at LS toe.					
FIELD_STRUCT_DESC: 24-inch CM stormdrain pipe through the levee,					
13.6 feet below the crown. Flap gate on the waterward end. Brass cap					
No. 100 BM on headwall on the landward side. (USACE-1967). This					
entry matches the Drainage or Irrigation Structure referenced in O&M					
manual (HLM 1.69).					
FS Date: 4/8/2014

Pipe, headwall, and flapgate visible on WS toe.

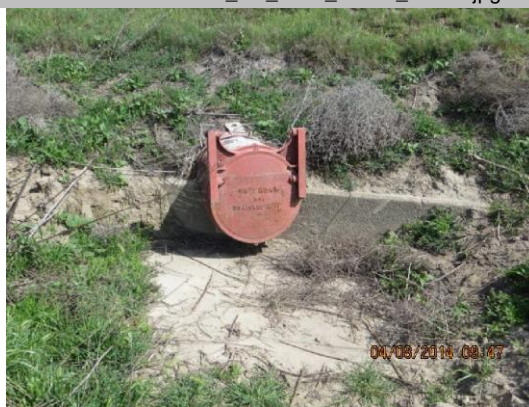
Photo 2 of 3 : UCIP\_SP\_2017\_33563\_60663.jpg

Pipe, headwall, and flapgate visible on WS toe.

LM Start	1.67	Rating **	M	Issue No.	1193 (cont)	
LM End	1.67	Issue Type +	Ma	Location *	LS	
Category	Supplemental			GPS Latitude/Longitude		
				Start		End
Item	DWR UCIP LMA Responsibility			37.336459 °		37.336459 °
				-120.944803 °		-120.944803 °
DWR ID						
Comment Code						
Inspector Comment						
FS_ID:33563						
DS_ID:19589						
EP_NO: N/A						
Repair Type: Non-Urgent						
Crossing Status: Found						
UCIP Comments: Heavy sediment buildup in pipe at LS toe.						
FIELD_STRUCT_DESC: 24-inch CM stormdrain pipe through the levee,						
13.6 feet below the crown. Flap gate on the waterward end. Brass cap						
No. 100 BM on headwall on the landward side. (USACE-1967). This						
entry matches the Drainage or Irrigation Structure referenced in O&M						
manual (HLM 1.69).						
FS Date: 4/8/2014

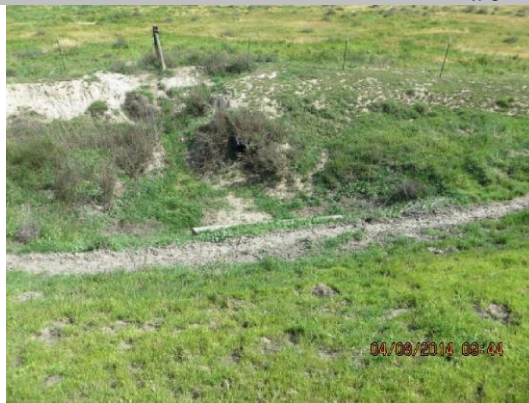
Photo 3 of 3 : UCIP\_SP\_2017\_33563\_60662.jpg

Pipe and headwall visible on LS toe.

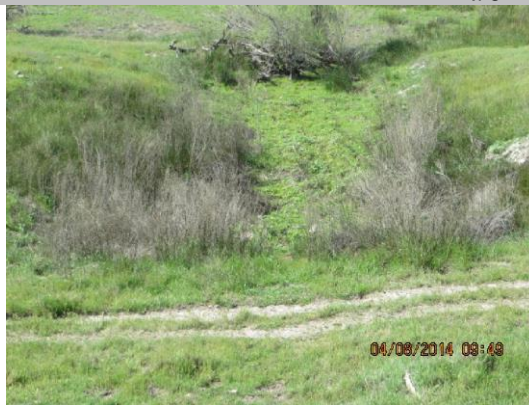
Photo 1 of 3 : UCIP\_SP\_2017\_33564\_60666.jpg

LM Start	1.81	Rating **	A/W	Issue No.	1194
LM End	1.81	Issue Type +	Ma	Location *	LS
Category	Supplemental			GPS Latitude/Longitude	
				Start	End
Item	DWR UCIP LMA Responsibility			37.335612 °	37.335612 °
				-120.942532 °	-120.942532 °
DWR ID					
Comment Code					
Inspector Comment					
FS_ID:33564 DS_ID:19590 EP_NO: N/A Repair Type: No Action Needed Crossing Status: Found UCIP Comments: FIELD_STRUCT_DESC: 36-inch CM stormdrain pipe through the levee, 14.2 feet below the crown. Flap gate on the waterward end. Brass cap No. 100 BM on headwall on the landward side. (USACE-1967). This entry matches the Drainage or Irrigation Structure referenced in O&M manual (HLM 1.83). FS Date: 4/8/2014

Pipe, flapgate, and headwall visible at WS toe.

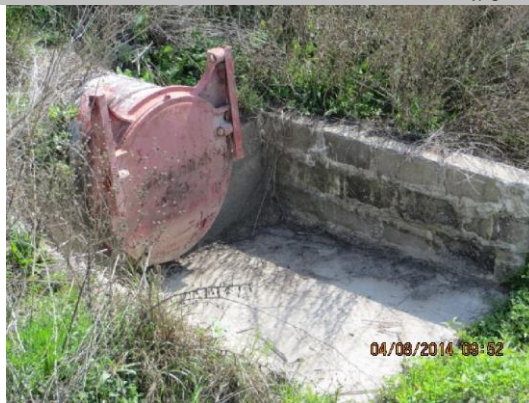
Photo 2 of 3 : UCIP\_SP\_2017\_33564\_60667.jpg

Pipe, flapgate, and headwall visible at WS toe.

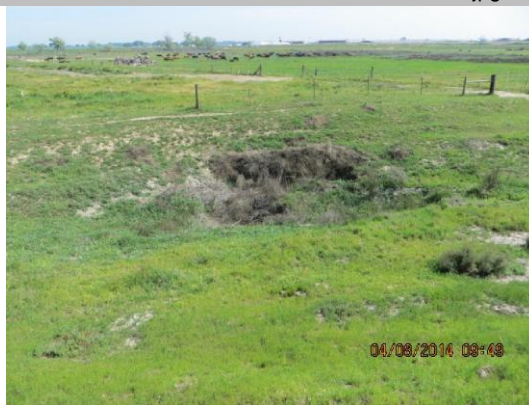
Photo 3 of 3 : UCIP\_SP\_2017\_33564\_60665.jpg

Pipe and concrete headwall visible at LS toe.

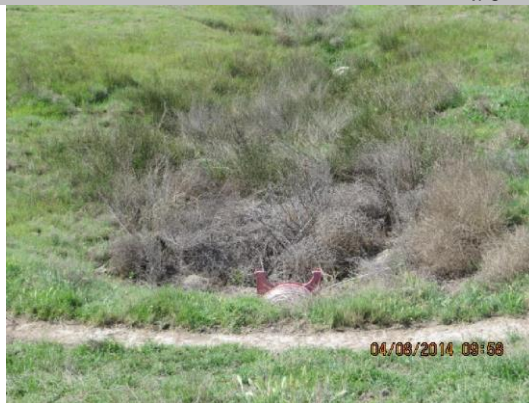
Photo 1 of 3 : UCIP\_SP\_2017\_39100\_60670.jpg

LM Start	1.95	Rating **	M	Issue No.	1195	
LM End	1.95	Issue Type +	Ma	Location *	LS	
Category	Supplemental			GPS Latitude/Longitude		
				Start		End
Item	DWR UCIP LMA Responsibility			37.334377 °		37.334377 °
				-120.940397 °		-120.940397 °
DWR ID						
Comment Code						
Inspector Comment						
FS_ID:39100 DS_ID:19591 EP_NO: N/A Repair Type: Non-Urgent Crossing Status: Found UCIP Comments: Need to contact owner to determine crossing status. Inlet drop box silted in and needs to be cleaned out. FIELD_STRUCT_DESC: 24-inch CM stormdrain pipe through the levee, 9.7 feet below the crown. Flap gate on the waterward end. Brass cap No. 100 BM on headwall on the landward side. (USACE-1967). Wooden barrier around drop inlet on LS toe. This entry matches the Drainage or Irrigation Structure referenced in O&M manual (HLM 1.98). FS Date: 4/8/2014

Concrete headwall and flapgate on WS toe.

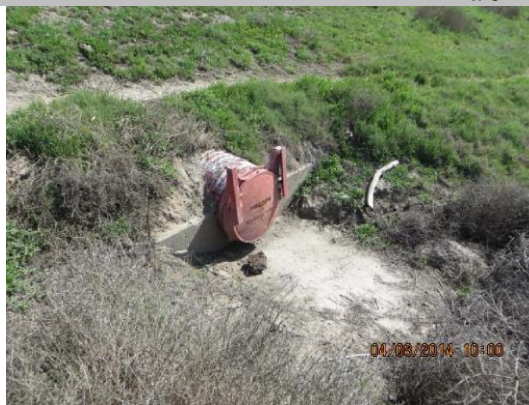
Photo 2 of 3 : UCIP\_SP\_2017\_39100\_60672.jpg

Pipe, flapgate, and headwall on WS toe.

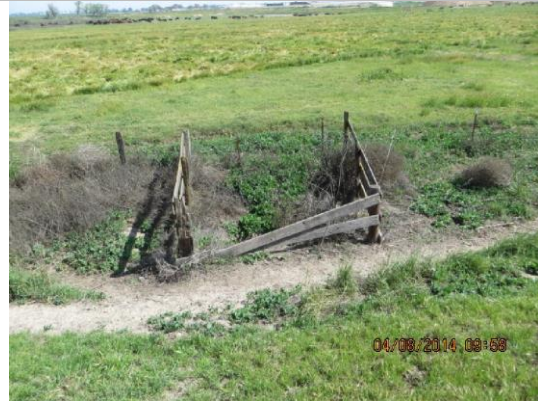
Photo 3 of 3 : UCIP\_SP\_2017\_39100\_60671.jpg

Wooded barrier around drop-inlet on LS toe.

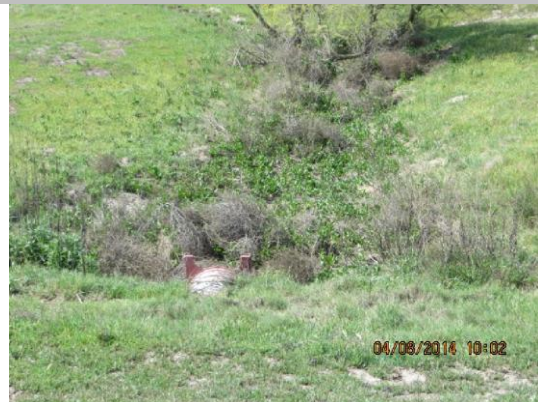
Photo 1 of 3 : UCIP\_SP\_2017\_39123\_60675.jpg

LM Start	2.06	Rating **	M	Issue No.	1196
LM End	2.06	Issue Type +	Ma	Location *	LS
Category	Supplemental			GPS Latitude/Longitude	
				Start	End
Item	DWR UCIP LMA Responsibility			37.333653 °	37.333653 °
				-120.938770 °	-120.938770 °
DWR ID					
Comment Code					
Inspector Comment					
FS_ID:39123 DS_ID:19570 EP_NO: N/A Repair Type: Non-Urgent Crossing Status: Found UCIP Comments: Unable to find inlet on landward toe. Recommend clearing vegetation on landward side to properly inspect inlet. FIELD_STRUCT_DESC: 24-inch CM stormdrain pipe through the levee, 9.8 feet below the crown. Flap gate on waterward end. Brass cap No. 100 BM on headwall on the landward side. (USACE-1967). This entry matches the Drainage or Irrigation Structure referenced in O&M manual (HLM 2.08). FS Date: 4/8/2014

Pipe and flapgate visible on WS toe.

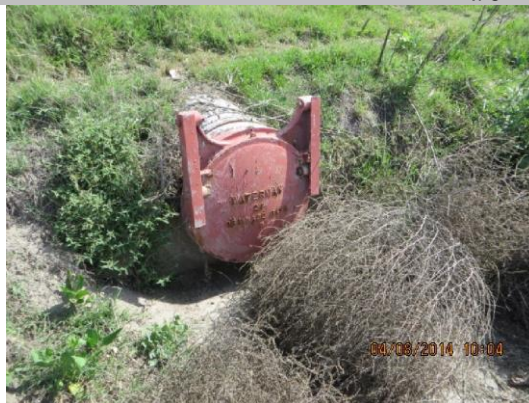
Photo 2 of 3 : UCIP\_SP\_2017\_39123\_60676.jpg

Pipe and flapgate visible on WS toe.

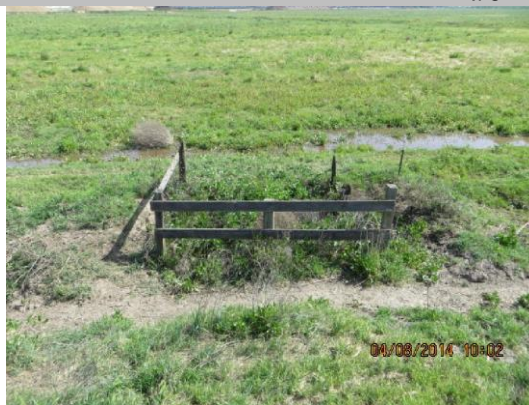
Photo 3 of 3 : UCIP\_SP\_2017\_39123\_60674.jpg

Wooded barrier around drop-inlet on LS toe.

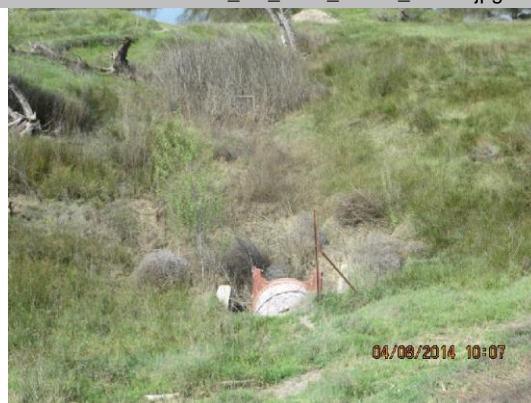
Photo 1 of 3 : UCIP\_SP\_2017\_39125\_71309.jpg

LM Start	2.22	Rating **	A/W	Issue No.	1197
LM End	2.22	Issue Type +	Ma	Location *	LS
Category	Supplemental			GPS Latitude/Longitude	
				Start	End
Item	DWR UCIP LMA Responsibility			37.331611 °	37.331611 °
				-120.937455 °	-120.937455 °
DWR ID					
Comment Code					
Inspector Comment					
FS_ID:39125					
DS_ID:19571					
EP_NO: N/A					
Repair Type: No Action Needed					
Crossing Status: Found					
UCIP Comments:					
FIELD_STRUCT_DESC: 36-inch CM stormdrain pipe through the levee, 12.6 feet below the crown. Flap gate on the waterward end. Brass cap No. 100 BM on headwall on the landward side. (USACE-1967). Wooded barrier around dropinlet on LS toe. This entry matches the Drainage or Irrigation Structure referenced in O&M manual (HLM 2.25). FS Date: 4/8/2014

Pipe and flapgate on WS toe.

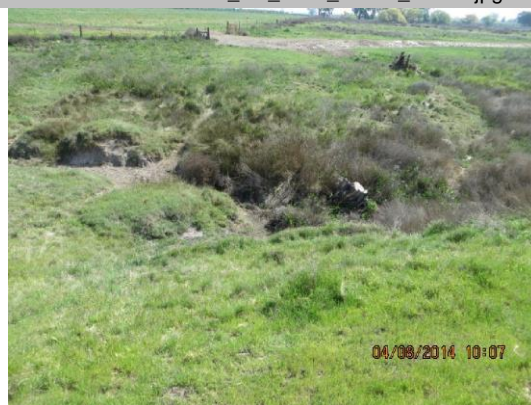
Photo 2 of 3 : UCIP\_SP\_2017\_39125\_71308.jpg

Pipe and headwall on LS toe.

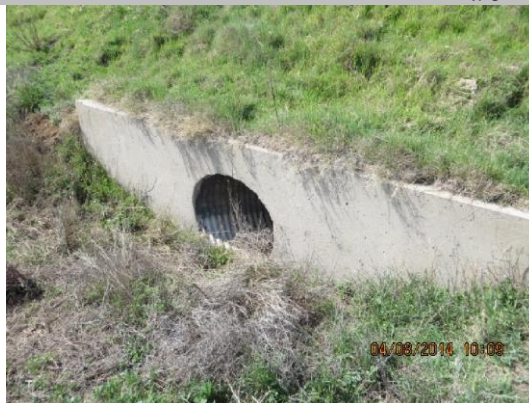
Photo 3 of 3 : UCIP\_SP\_2017\_39125\_71307.jpg

Pipe and headwall on LS toe.

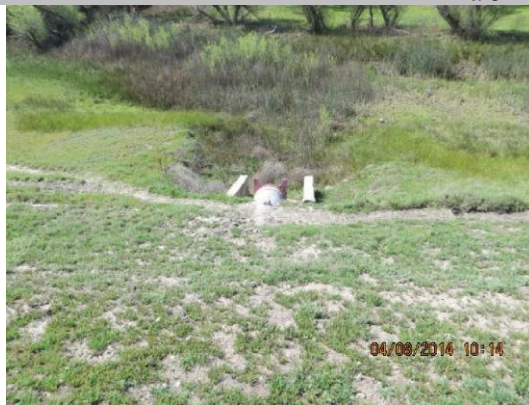
Photo 1 of 3 : UCIP\_SP\_2017\_33568\_60679.jpg

LM Start	2.50	Rating **	A/W	Issue No.	1198
LM End	2.50	Issue Type +	Ma	Location *	LS
Category	Supplemental			GPS Latitude/Longitude	
				Start	End
Item	DWR UCIP LMA Responsibility			37.328619 °	37.328619 °
				-120.934369 °	-120.934369 °
DWR ID					
Comment Code					
Inspector Comment					
FS_ID:33568 DS_ID:19572 EP_NO: N/A Repair Type: No Action Needed Crossing Status: Found UCIP Comments: FIELD_STRUCT_DESC: 24-inch CM pipe through the levee, 8.0 feet below the crown. Flap gate on the waterward end. Brass cap No. 100 BM on headwall on the landward side. (USACE-1967). This entry matches the Drainage or Irrigation Structure referenced in O&M manual (HLM 2.52). FS Date: 4/8/2014

Pipe, headwall, and flapgate on WS toe.

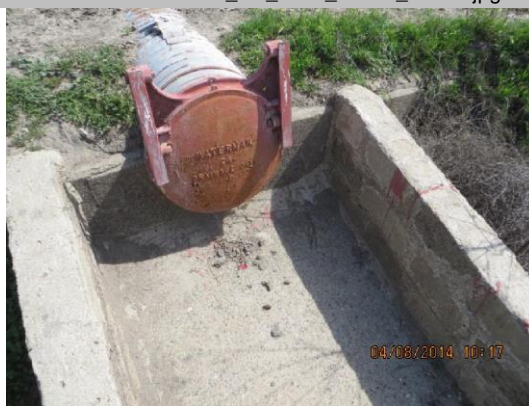
Photo 2 of 3 : UCIP\_SP\_2017\_33568\_60680.jpg

Pipe, headwall, and flapgate on WS toe.

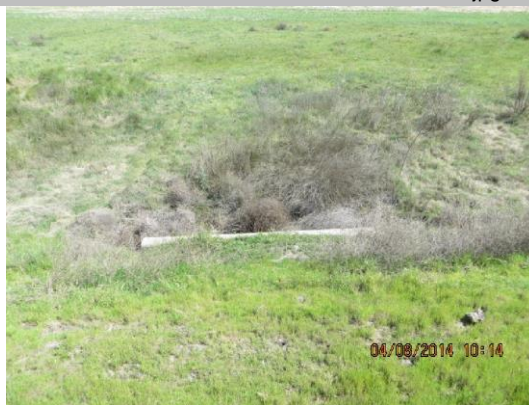
Photo 3 of 3 : UCIP\_SP\_2017\_33568\_60678.jpg

Pipe and headwall on LS toe.

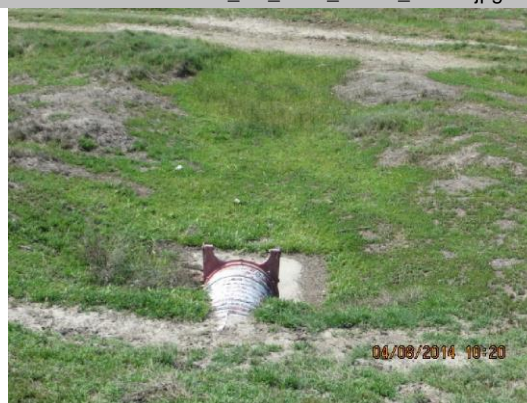
Photo 1 of 3 : UCIP\_SP\_2017\_39127\_60688.jpg

LM Start	2.67	Rating **	M	Issue No.	1199
LM End	2.67	Issue Type +	Ma	Location *	LS
Category	Supplemental			GPS Latitude/Longitude	
				Start	End
Item	DWR UCIP LMA Responsibility			37.327362 °	37.327362 °
				-120.931591 °	-120.931591 °
DWR ID					
Comment Code					
Inspector Comment					
FS_ID:39127					
DS_ID:19573					
EP_NO: N/A					
Repair Type: Non-Urgent					
Crossing Status: Found					
UCIP Comments: Sedimentation in pipe at landward toe.					
FIELD_STRUCT_DESC: 24-inch CM stormdrain pipe through the levee,					
7.3 feet below the crown. Flap gate on the waterward end. Brass cap					
No. 100 BM on headwall on the landward side. (USACE-1967). This					
entry matches the Drainage or Irrigation Structure referenced in O&M					
manual (HLM 2.70).					
FS Date: 4/8/2014

Pipe, flapgate, and headwall on WS toe.

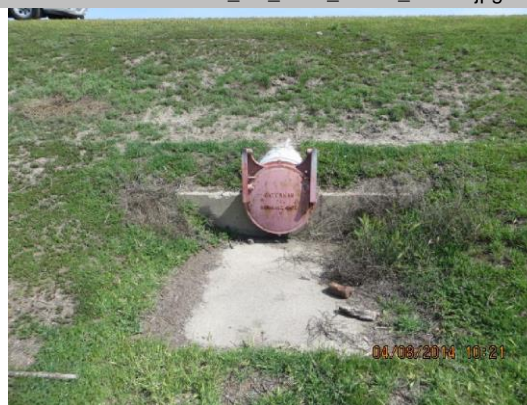
Photo 2 of 3 : UCIP\_SP\_2017\_39127\_60689.jpg

Pipe, flapgate, and headwall on WS toe.

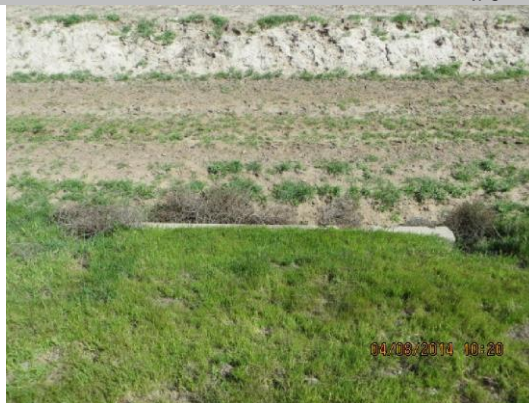
Photo 3 of 3 : UCIP\_SP\_2017\_39127\_60687.jpg

Pipe and headwall on LS toe.

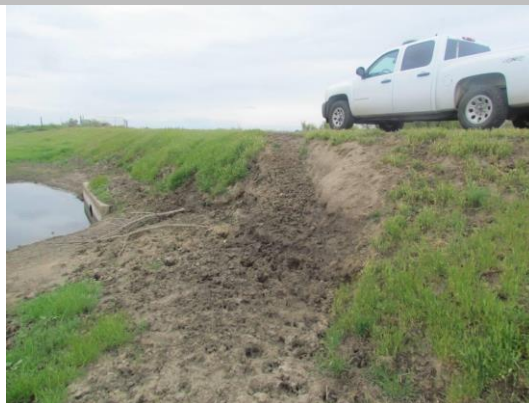
Photo 1 of 1 : SP\_2017\_NA0010\_118\_108\_20170424\_00271.jpg

LM Start	3.13	Rating **	M	Issue No.	108
LM End	3.13	Issue Type +	Ma	Location *	LS
Category	Earthen Levee			GPS Latitude/Longitude	
				Start	End
Item	Slope Stability			37.321468 °	37.321468 °
				-120.928757 °	-120.928757 °
DWR ID	DWR_NA0010_01_s_2017_108				
Comment Code					
S2 : Repair the levee slope damaged by foot traffic and prevent access where possible.					
Inspector Comment					
Slope damage caused by animal traffic on landward toe.

Looking west at slope damage caused by animal traffic.

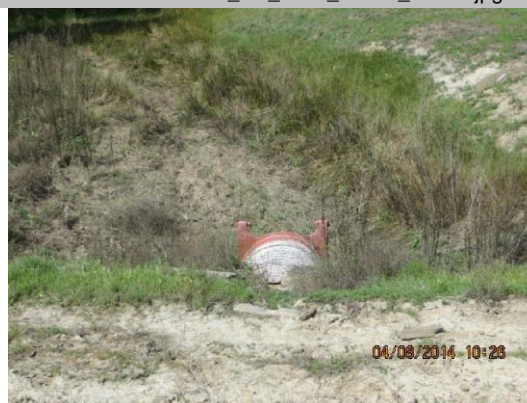
Photo 1 of 3 : UCIP\_SP\_2017\_39128\_60702.jpg

LM Start	3.13	Rating **	M	Issue No.	1200
LM End	3.13	Issue Type +	Ma	Location *	LS
Category	Supplemental			GPS Latitude/Longitude	
				Start	End
Item	DWR UCIP LMA Responsibility			37.321444 °	37.321444 °
				-120.928764 °	-120.928764 °
DWR ID					
Comment Code					
Inspector Comment					
FS_ID:39128					
DS_ID:19574					
EP_NO: N/A					
Repair Type: Non-Urgent					
Crossing Status: Found					
UCIP Comments: Some minor erosion around headwall on LS toe.					
FIELD_STRUCT_DESC: 36-inch CM pipe through the levee, 8-feet below the crown. Flap gate on the waterward end. Brass cap No. 100					
BM on headwall on the landward side. (USACE-1967). This entry matches the Drainage or Irrigation Structure referenced in O&M manual (HLM 3.16).					
FS Date: 4/8/2014

Pipe, Flapgate, and headwall on WS toe.

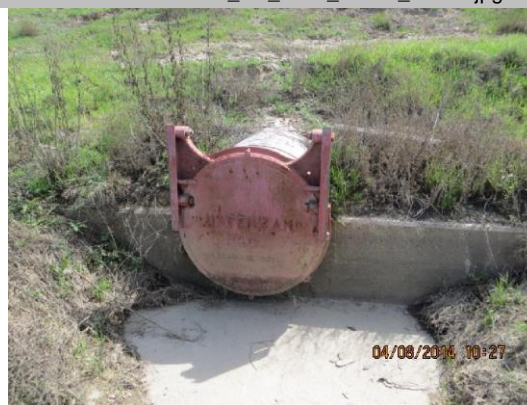
Photo 2 of 3 : UCIP\_SP\_2017\_39128\_60700.jpg

Pipe, Flapgate, and headwall on WS toe.

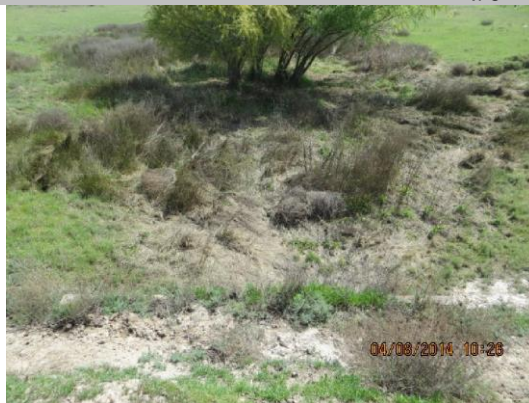
Photo 3 of 3 : UCIP\_SP\_2017\_39128\_60701.jpg

Pipe and headwall on LS toe.

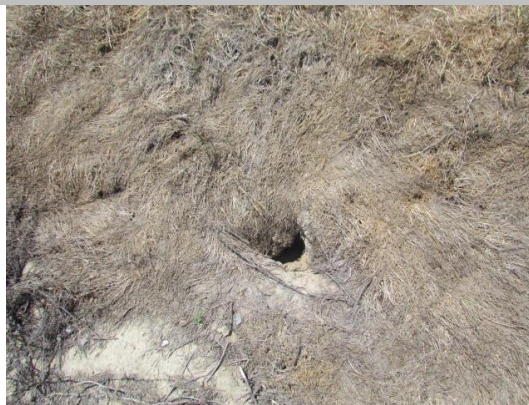
Photo 1 of 2 : SP\_2017\_NA0010\_118\_10\_20170417\_00008.jpg

LM Start	3.16	Rating **	M	Issue No.	10
LM End	3.16	Issue Type +	Ma	Location *	LS
Category	Earthen Levee			GPS Latitude/Longitude	
				Start	End
Item	Animal Control			37.321053 °	37.321053 °
				-120.928785 °	-120.928785 °
DWR ID	DWR_NA0010_01_s_2012_10				
Comment Code					
A3 : No rodents visible, but rodent burrows visible; need to backfill and compact or grout burrows.					
Inspector Comment					
Several rodent holes noted within this section. Rodent hole noted on waterward shoulder next to fence pole.

Looking at typical view of rodent holes on landward slope.

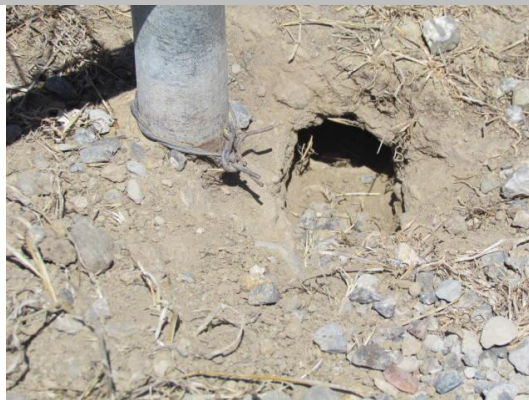
Photo 2 of 2 : SP\_2017\_NA0010\_118\_10\_20170417\_00009.jpg

LM Start	3.16	Rating **	M	Issue No.	10 (cont)	
LM End	3.16	Issue Type +	Ma	Location *	LS	
Category	Earthen Levee			GPS Latitude/Longitude		
				Start		End
Item	Animal Control			37.321053 °		37.321053 °
				-120.928785 °		-120.928785 °
DWR ID	DWR_NA0010_01_s_2012_10					
Comment Code						
A3 : No rodents visible, but rodent burrows visible; need to backfill and compact or grout burrows.						
Inspector Comment						
Several rodent holes noted within this section. Rodent hole noted on waterward shoulder next to fence pole.

Looking at rodent hole next to fence pole on landward shoulder.

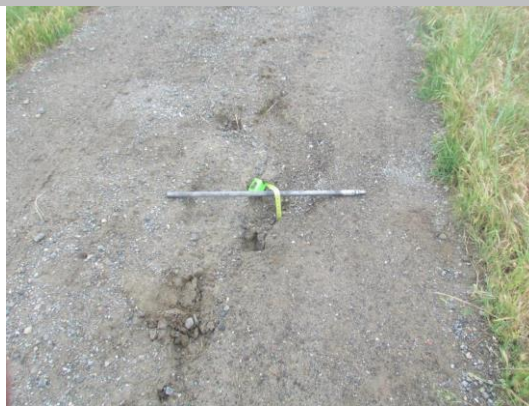
Photo 1 of 4 : SP\_2017\_NA0010\_118\_109\_20170424\_00272.jpg

LM Start	3.26	Rating **	U	Issue No.	109
LM End	3.29	Issue Type +	Ma	Location *	CR
Category	Earthen Levee			GPS Latitude/Longitude	
				Start	End
Item	Crown Surface / Depressions / Rutting			37.319740 °	37.319300 °
				-120.928308 °	-120.927903 °
DWR ID	DWR_NA0010_01_s_2017_109				
Comment Code					
C2 : Repair depressions or ruts in the crown or slope.					
Inspector Comment					
Depression (sinkhole) on levee crown and other depressions

Looking south at sinkhole on levee crown

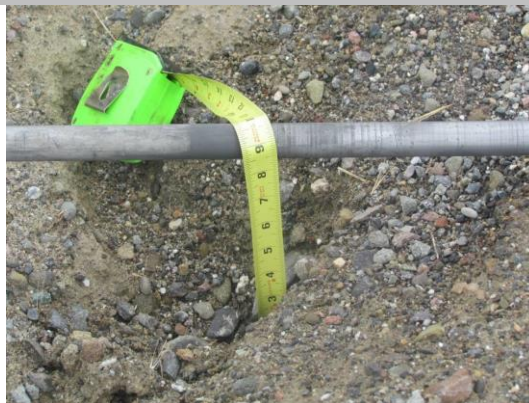
Photo 2 of 4 : SP\_2017\_NA0010\_118\_109\_20170424\_00273.jpg

Looking south at close view of sinkhole on levee crown

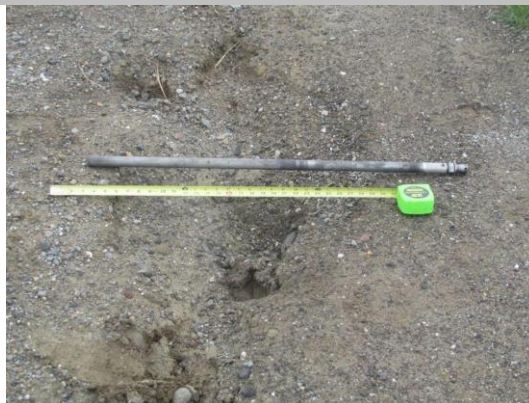
Photo 3 of 4 : SP\_2017\_NA0010\_118\_109\_20170424\_00274.jpg

LM Start	3.26	Rating **	U	Issue No.	109 (cont)	
LM End	3.29	Issue Type +	Ma	Location *	CR	
Category	Earthen Levee			GPS Latitude/Longitude		
				Start		End
Item	Crown Surface / Depressions / Rutting			37.319740 °		37.319300 °
				-120.928308 °		-120.927903 °
DWR ID	DWR_NA0010_01_s_2017_109					
Comment Code						
C2 : Repair depressions or ruts in the crown or slope.						
Inspector Comment						
Depression (sinkhole) on levee crown and other depressions

Looking south at sinkhole on levee crown.

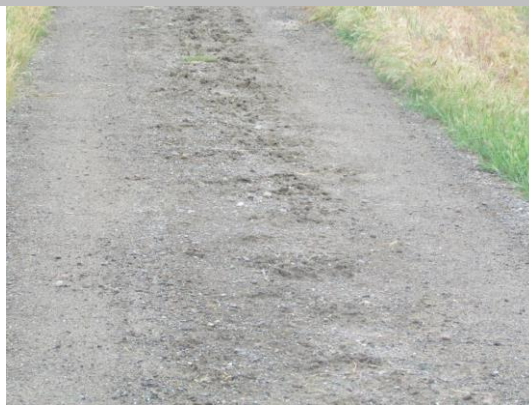
Photo 4 of 4 : SP\_2017\_NA0010\_118\_109\_20170424\_00275.jpg

Looking south at rutting on levee crown.

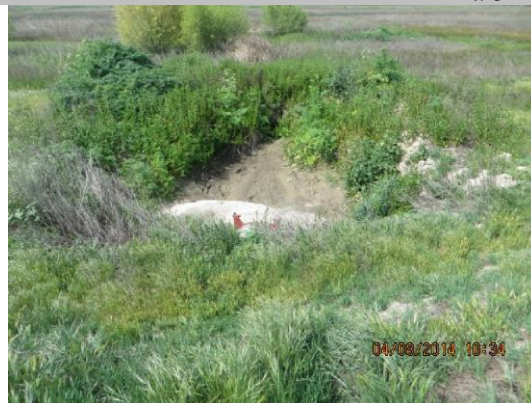
Photo 1 of 3 : UCIP\_SP\_2017\_50054\_60707.jpg

FS\_ID:50054  
DS\_ID:19575  
EP\_NO: N/A  
Repair Type: Urgent  
Crossing Status: Found  
UCIP Comments: 7/19/2016 Same as previous inspection. Erosion present on LS slope. (DWR UCIP - omagana)4/08/2014 Pipe rusted through at Springline on LS toe. Flapgate blocked by sediment on WS toe. Heavy sediment on both ends of pipe. Need to contact owner to address issues. (DWR UCIP - omagana)  
FIELD\_STRUCT\_DESC: 36-inch corrugated metal drainage pipe through the levee, 9.7 feet below the crown. Flap gate located on the waterside (WS) end. Brass cap No. 100 BM on headwall located on the landside (LS). [Additional Reference(s): DWR Levee Log, 2002. USACE San Joaquin O&M Manuals: Unit No. 601, 1967, (HLM 3.50), Unit No. 601 Part I, 1967 (Amended in 1978), Unit No. 601 Part II, 1969, and Unit No. 601 Part III, 1969].  
FS Date: 7/19/2016

Pipe, headwall, and flapgate on WS toe.

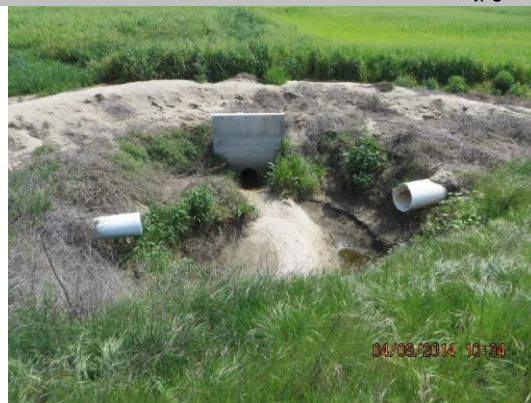
Photo 2 of 3 : UCIP\_SP\_2017\_50054\_60706.jpg

Pipe and headwall on LS toe.

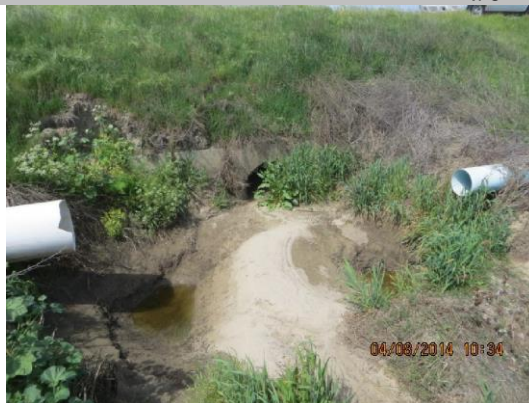
Photo 3 of 3 : UCIP\_SP\_2017\_50054\_60705.jpg

Comment Code					
Inspector Comment					
FS_ID:50054 DS_ID:19575 EP_NO: N/A Repair Type: Urgent Crossing Status: Found UCIP Comments: 7/19/2016 Same as previous inspection. Erosion present on LS slope. (DWR UCIP - omagana)4/08/2014 Pipe rusted through at Springline on LS toe. Flapgate blocked by sediment on WS toe. Heavy sediment on both ends of pipe. Need to contact owner to address issues. (DWR UCIP - omagana) FIELD_STRUCT_DESC: 36-inch corrugated metal drainage pipe through the levee, 9.7 feet below the crown. Flap gate located on the waterside (WS) end. Brass cap No. 100 BM on headwall located on the landside (LS). [Additional Reference(s): DWR Levee Log, 2002. USACE San Joaquin O&M Manuals: Unit No. 601, 1967, (HLM 3.50), Unit No. 601 Part I, 1967 (Amended in 1978), Unit No. 601 Part II, 1969, and Unit No. 601 Part III, 1969]. FS Date: 7/19/2016

Pipe and headwall on LS toe.

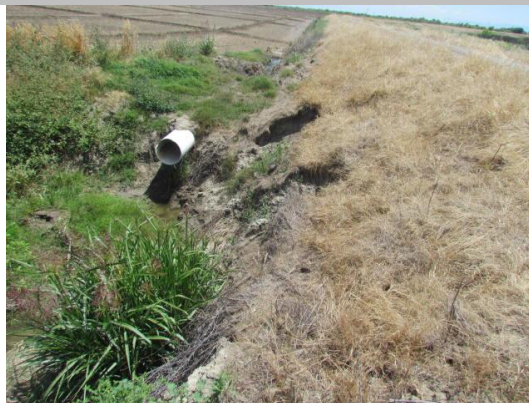
Photo 1 of 3 : SP\_2017\_NA0010\_118\_1179\_20170417\_00029.jpg

LM Start	3.47	Rating **	U	Issue No.	1179
LM End	3.47	Issue Type +	Ma	Location *	LS
Category	Earthen Levee			GPS Latitude/Longitude	
				Start	End
Item	Erosion / Bank Caving			37.317057 °	37.317057 °
				-120.926443 °	-120.926443 °
DWR ID	DWR_NA0010_01_s_2015_1179				
Comment Code					
E2 : Schedule repair of erosion site prior to the next inspection.					
Inspector Comment					
Several erosions greater than three inches on landward slope.

Looking south at erosion on landward slope and toe.

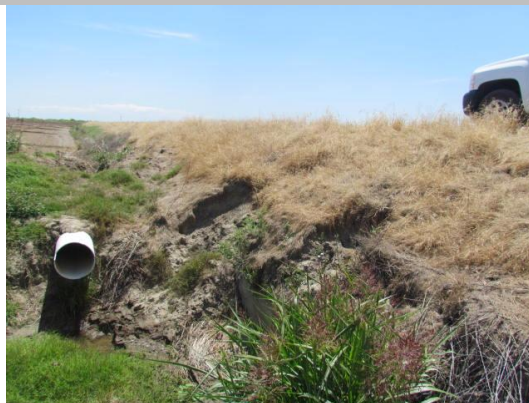
Photo 2 of 3 : SP\_2017\_NA0010\_118\_1179\_20170417\_00030.jpg

LM Start	3.47	Rating **	U	Issue No.	1179 (cont)	
LM End	3.47	Issue Type +	Ma	Location *	LS	
Category	Earthen Levee			GPS Latitude/Longitude		
				Start		End
Item	Erosion / Bank Caving			37.317057 °		37.317057 °
				-120.926443 °		-120.926443 °
DWR ID	DWR_NA0010_01_s_2015_1179					
Comment Code						
E2 : Schedule repair of erosion site prior to the next inspection.						
Inspector Comment						
Several erosions greater than three inches on landward slope.

Looking southwest at erosion on landward slope and toe.

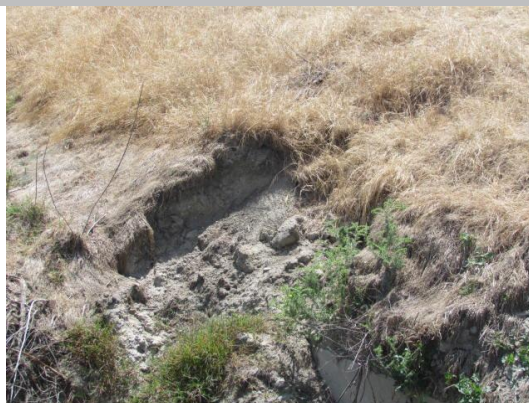
Photo 3 of 3 : SP\_2017\_NA0010\_118\_1179\_20170417\_00031.jpg

Looking west at erosion on landward slope and toe.

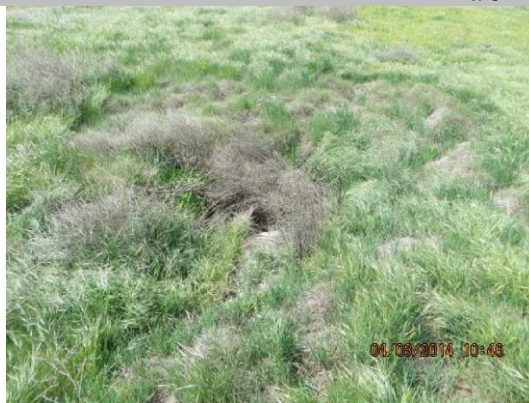
Photo 1 of 3 : UCIP\_SP\_2017\_39132\_60723.jpg

Comment Code					
Inspector Comment					
FS_ID:39132 DS_ID:19576 EP_NO: N/A Repair Type: Non-Urgent Crossing Status: Found UCIP Comments: Slide gate missing from WS. No closure device, but degrading of levee at Highway 140 is lower than pipe, so this does not appear to be a critical issue. Also dense vegetation limits the inspector's visibility to identify signs of pipe failure (leaks) along the slope. Recommend removing vegetation along pipe alignment to conduct proper inspection of structure and appurtenances. FIELD_STRUCT_DESC: 30-inch CM irrigation pipe through the levee, 3.5 feet below the crown. Slidegate on the waterward end. Brass cap No. 100 BM on headwall on the landward side. (USACE-1967). This entry matches the Drainage or Irrigation Structure referenced in O&M manual (HLM 3.95). FS Date: 4/8/2014

Slide gate missing on WS toe with heavy vegetation camouflaging pipe

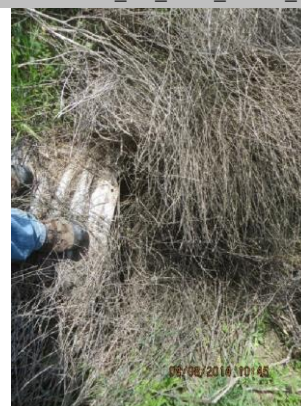
Photo 2 of 3 : UCIP\_SP\_2017\_39132\_60720.jpg

Item	DWR UCIP Field Study			37.311178 °		37.311178 °
				-120.927007 °		-120.927007 °
DWR ID						
Comment Code						
Inspector Comment						
FS_ID:39132 DS_ID:19576 EP_NO: N/A Repair Type: Non-Urgent Crossing Status: Found UCIP Comments: Slide gate missing from WS. No closure device, but degrading of levee at Highway 140 is lower than pipe, so this does not appear to be a critical issue. Also dense vegetation limits the inspector's visibility to identify signs of pipe failure (leaks) along the slope. Recommend removing vegetation along pipe alignment to conduct proper inspection of structure and appurtenances. FIELD_STRUCT_DESC: 30-inch CM irrigation pipe through the levee, 3.5 feet below the crown. Slidegate on the waterward end. Brass cap No. 100 BM on headwall on the landward side. (USACE-1967). This entry matches the Drainage or Irrigation Structure referenced in O&M manual (HLM 3.95). FS Date: 4/8/2014

Slide gate missing on WS toe with heavy vegetation camouflaging pipe

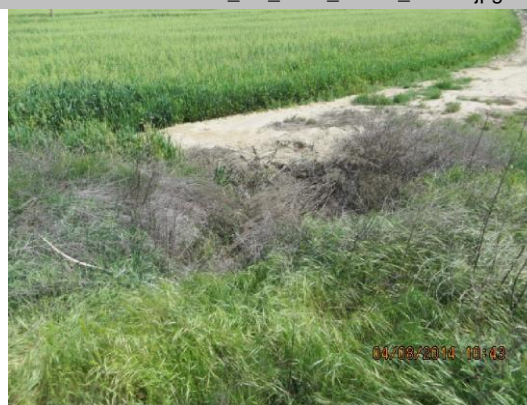
Photo 3 of 3 : UCIP\_SP\_2017\_39132\_60722.jpg

Concrete headwall in heavy vegetation at LS toe.

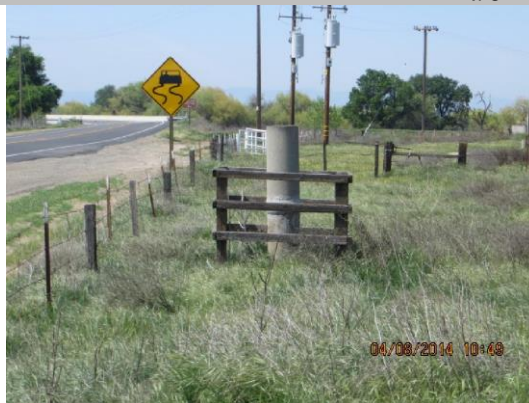
Photo 1 of 2 : UCIP\_SP\_2017\_39133\_60725.jpg

LM Start	3.93	Rating **	M	Issue No.	1203
LM End	3.93	Issue Type +	En	Location *	LS
Category	Supplemental			GPS Latitude/Longitude	
				Start	End
Item	DWR UCIP Field Study			37.311157°	37.311157°
				-120.926919°	-120.926919°
DWR ID					
Comment Code					
Inspector Comment					
FS_ID:39133					
DS_ID:19606					
EP_NO: N/A					
Repair Type: Non-Urgent					
Crossing Status: Indicator Found					
UCIP Comments: Need to contact owner to determine status of crossing inlet and outlet not found.					
FIELD_STRUCT_DESC: 12-inch concrete irrigation pipe through the levee, 3.5 feet below the crown. 12-inch Concrete standpipes off both sides of levee.					
FS Date: 4/8/2014

12-inch concrete standpipe off WS toe.

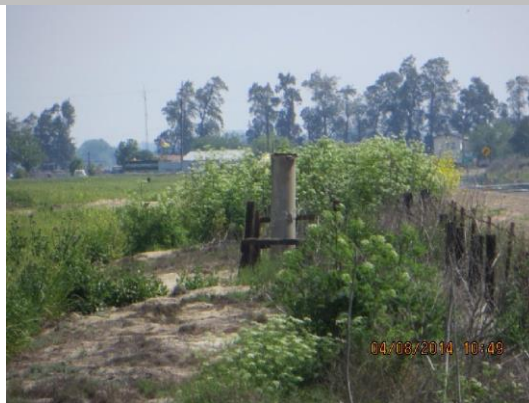
Photo 2 of 2 : UCIP\_SP\_2017\_39133\_60724.jpg

12-inch concrete standpipe off LS toe.
