**Flood Control Project Maintenance  
Levee Inspections**  
**LMA District Cover Sheet**  
**Spring 2017 Levee Inspection Results**

**Lower San Joaquin Levee District**

Waterway			Bank	Unit Miles
Unit No. 01 San Joaquin River			Right	22.52
	Spring (March - May)	Summer (June - August)	(September - November) Fall	Winter (December - February)
Unit Maintenance Rating (Fall Only)				
Date of Inspection	4/17/2017 - 4/20/2017			
DWR Inspector	Richard Willoughby			
Accompanied By

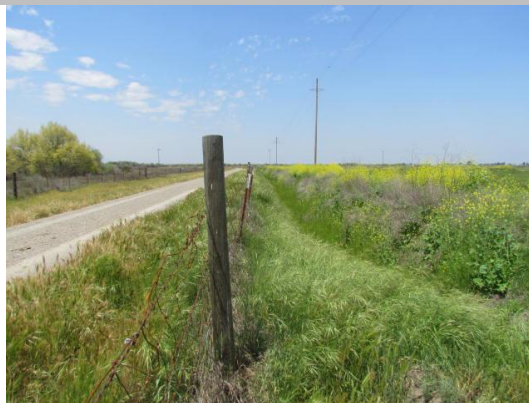
Photo 1 of 2 : SP\_2017\_NA0010\_118\_5\_20170417\_00003.jpg

LM Start	3.98	Rating **	U	Issue No.	5
LM End	4.05	Issue Type +	En	Location *	LS
Category	Earthen Levee			GPS Latitude/Longitude	
				Start	End
Item	Encroachments			37.310837 °	37.310003 °
				-120.926182 °	-120.925313 °
DWR ID	DWR_NA0010_01_s_2012_5				
Comment Code					
DT : Ditch					
Inspector Comment					
Irrigation ditch at landside toe

Looking north at irrigation ditch at landside toe.

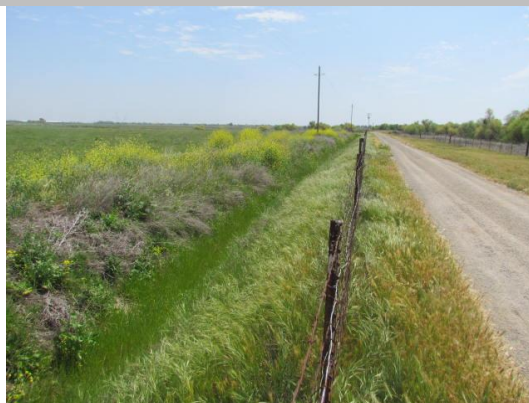
Photo 2 of 2 : SP\_2017\_NA0010\_118\_5\_20170417\_00004.jpg

Looking south at irrigation ditch at landside toe.

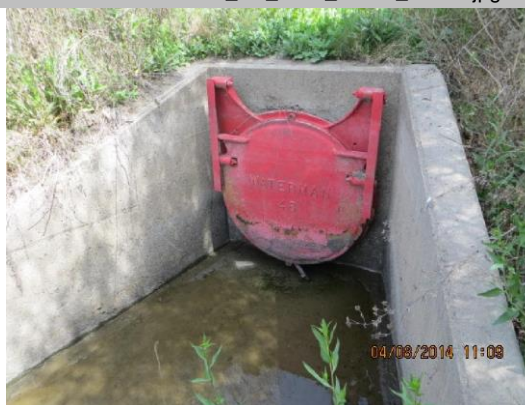
Photo 1 of 3 : UCIP\_SP\_2017\_39134\_60730.jpg

Comment Code					
Inspector Comment					
FS_ID:39134 DS_ID:19607 EP_NO: N/A Repair Type: Non-Urgent Crossing Status: Found UCIP Comments: Pipe appears sleeved with a 12-inch steel pipe with a slide gate at the LS toe. No identified authorization for changes to this crossing. Need to contact owner to obtain additional information about the modifications to crossing. FIELD_STRUCT_DESC: 48-inch CM stormdrain pipe through the levee, 14.0 feet below the crown. Flap gate on the waterward end. Brass cap No. 90 BM on headwall on the landward side. (USACE-1967). This entry matches the Drainage or Irrigation Structure referenced in O&M manual (HLM 4.16). FS Date: 4/8/2014

Concrete headwall and 48-inch flapgate visible on WS toe.

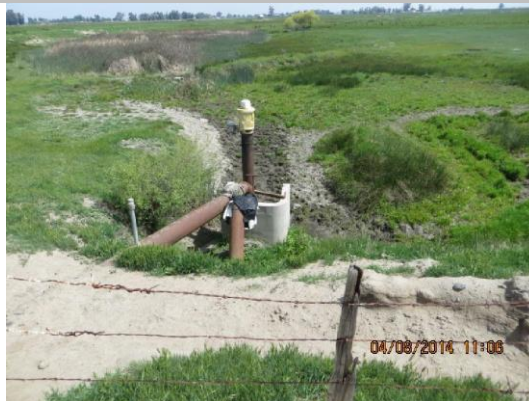
Photo 2 of 3 : UCIP\_SP\_2017\_39134\_60731.jpg

Item	DWR UCIP LMA Responsibility			37.309080 °		37.309080 °
				-120.924442 °		-120.924442 °
DWR ID						
Comment Code						
Inspector Comment						
FS_ID:39134						
DS_ID:19607						
EP_NO: N/A						
Repair Type: Non-Urgent						
Crossing Status: Found						
UCIP Comments: Pipe appears sleeved with a 12-inch steel pipe with a slide gate at the LS toe. No identified authorization for changes to this crossing. Need to contact owner to obtain additional information about the modifications to crossing.						
FIELD_STRUCT_DESC: 48-inch CM stormdrain pipe through the levee, 14.0 feet below the crown. Flap gate on the waterward end. Brass cap No. 90 BM on headwall on the landward side. (USACE-1967). This entry matches the Drainage or Irrigation Structure referenced in O&M manual (HLM 4.16).						
FS Date: 4/8/2014

Assumed pipe exists under pump at LS toe.

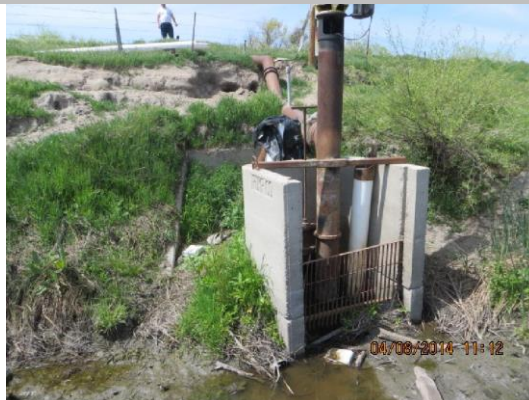
Photo 3 of 3 : UCIP\_SP\_2017\_39134\_60729.jpg

Concrete inlet, slidegate, and concrete headwall at LS toe.

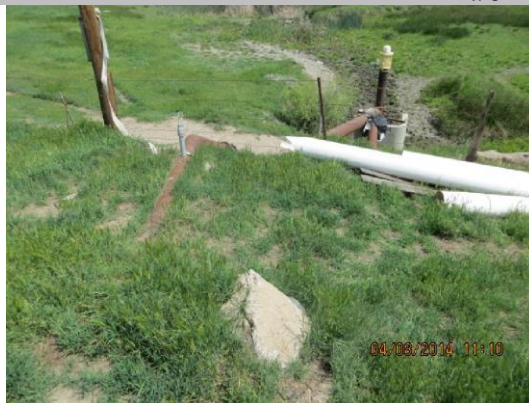
Photo 1 of 2 : UCIP\_SP\_2017\_39138\_71320.jpg

LM Start	4.13	Rating **	M	Issue No.	1205
LM End	4.13	Issue Type +	En	Location *	WS
Category	Supplemental			GPS Latitude/Longitude	
				Start	End
Item	DWR UCIP Field Study			37.309063 °	37.309063 °
				-120.924449 °	-120.924449 °
DWR ID					
Comment Code					
Inspector Comment					
FS_ID:39138 DS_ID:24866 EP_NO: N/A Repair Type: Non-Urgent Crossing Status: Found UCIP Comments: Need to contact owner to get details of crossing. FIELD_STRUCT_DESC: 12-inch steel stormdrain pipe through the levee 2.5-feet below the crown. 12-inch steel pipe, vent, and pump on stand visible on LS slope. 10-inch PVC pipe visible on WS slope. FS Date: 4/8/2014

View of pipe visible on landward side.

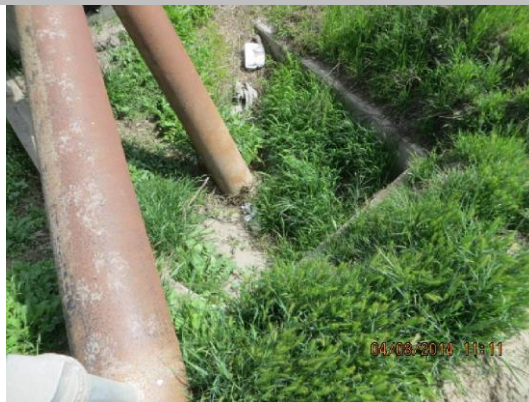
Photo 2 of 2 : UCIP\_SP\_2017\_39138\_71319.jpg

Pipe through existing 48 inch pipe.

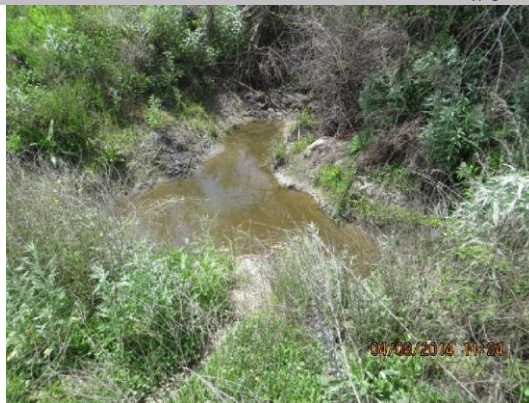
Photo 1 of 3 : UCIP\_SP\_2017\_39140\_60733.jpg

Comment Code					
Inspector Comment					
FS_ID:39140 DS_ID:19608 EP_NO: N/A Repair Type: Non-Urgent Crossing Status: Found UCIP Comments: Dense vegetation and fence limits the inspector's visibility to identify signs of pipe failure (leaks) along the landward side. Recommend obtaining access to landward toe and removing vegetation along pipe alignment to conduct proper inspection of structure and appurtenances. FIELD_STRUCT_DESC: 24-inch CM stormdrain pipe through the levee, 11.9 feet below the crown. Flap gate on the waterward end. Brass cap No. 90 BM on headwall on the landward side. (USACE-1967). This entry matches the Drainage or Irrigation Structure referenced in O&M manual (HLM 4.27). FS Date: 4/8/2014

Pipe, flapgate, and headwall visible at WS toe.

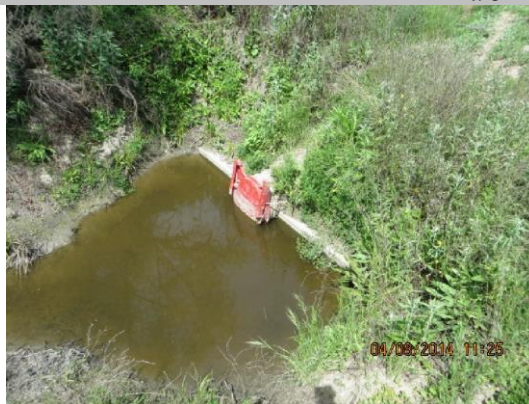
Photo 2 of 3 : UCIP\_SP\_2017\_39140\_60732.jpg

Pipe, flapgate, and headwall visible at WS toe.

Item	DWR UCIP LMA Responsibility			37.307930 °		37.307930 °
				-120.923057 °		-120.923057 °
DWR ID						
Comment Code						
Inspector Comment						
FS_ID:39140 DS_ID:19608 EP_NO: N/A Repair Type: Non-Urgent Crossing Status: Found UCIP Comments: Dense vegetation and fence limits the inspector's visibility to identify signs of pipe failure (leaks) along the landward side. Recommend obtaining access to landward toe and removing vegetation along pipe alignment to conduct proper inspection of structure and appurtenances. FIELD_STRUCT_DESC: 24-inch CM stormdrain pipe through the levee, 11.9 feet below the crown. Flap gate on the waterward end. Brass cap No. 90 BM on headwall on the landward side. (USACE-1967). This entry matches the Drainage or Irrigation Structure referenced in O&M manual (HLM 4.27). FS Date: 4/8/2014

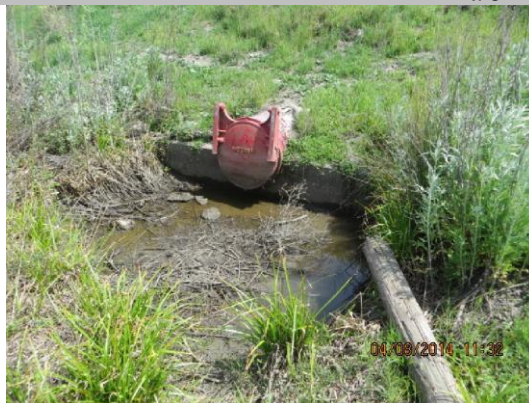
Photo 2 of 3 : UCIP\_SP\_2017\_39141\_60738.jpg

Item	DWR UCIP LMA Responsibility			37.302408 °	37.302408 °	
				-120.920931 °	-120.920931 °	
DWR ID						
Comment Code						
Inspector Comment						
FS_ID:39141						
DS_ID:19609						
EP_NO: N/A						
Repair Type: Non-Urgent						
Crossing Status: Found						
UCIP Comments: Dense vegetation limits the inspector's visibility to						
identify signs of pipe failure (leaks) along the waterward side.						
Recommend removing vegetation along pipe alignment to conduct						
proper inspection of structure and appurtenances.						
FIELD_STRUCT_DESC: 24-inch CM stormdrain pipe through the levee,

Pipe, flapgate, and headwall on WS toe.

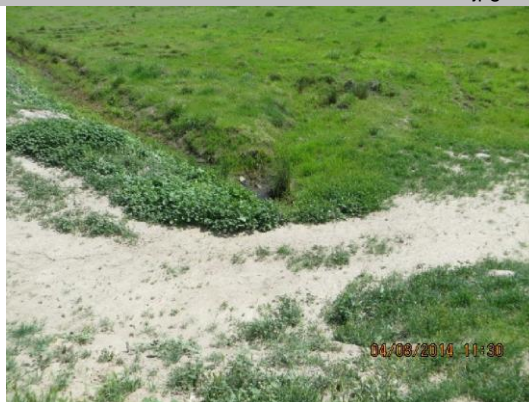
Photo 3 of 3 : UCIP\_SP\_2017\_39141\_60736.jpg

Pipe and concrete headwall on LS toe.

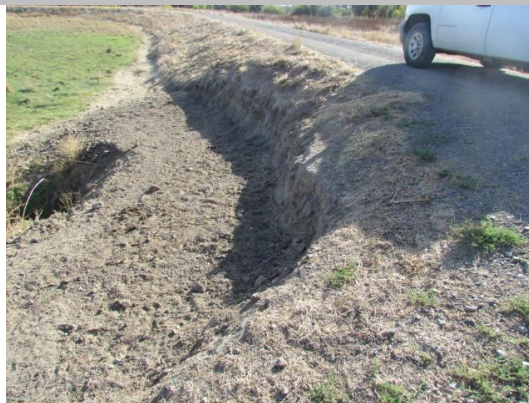
Photo 1 of 1 : SP\_2017\_NA0010\_118\_9\_20170417\_00007.jpg

LM Start	4.69	Rating **	U	Issue No.	9
LM End	4.69	Issue Type +	Ma	Location *	LS
Category	Earthen Levee			GPS Latitude/Longitude	
				Start	End
Item	Animal Control			37.302398 °	37.302398 °
				-120.920920 °	-120.920920 °
DWR ID	DWR_NA0010_01_s_2013_9				
Comment Code					
A2 : Repair the levee slope damaged by livestock and prevent large animal access.					
Inspector Comment					
Levee landward toe damaged by livestock.

Looking at landward slope damaged by livestock.

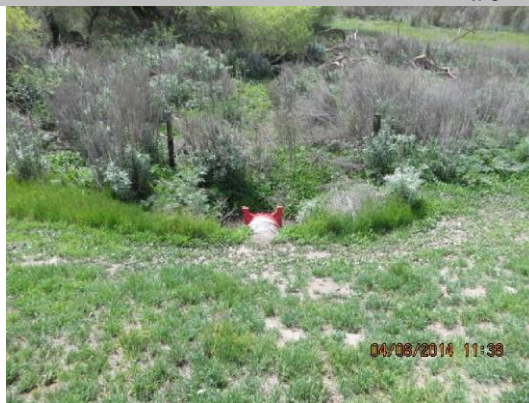
Photo 1 of 2 : UCIP\_SP\_2017\_39143\_60740.jpg

LM Start	5.02	Rating **	M	Issue No.	1208
LM End	5.02	Issue Type +	Ma	Location *	LS
Category	Supplemental			GPS Latitude/Longitude	
				Start	End
Item	DWR UCIP LMA Responsibility			37.298917 °	37.298917 °
				-120.917262 °	-120.917262 °
DWR ID					
Comment Code					
Inspector Comment					
FS_ID:39143 DS_ID:19610 EP_NO: N/A Repair Type: Non-Urgent Crossing Status: Found UCIP Comments: Non-functional -- sediment buildup against flapgate and inlet buried at landward side. FIELD_STRUCT_DESC: 24-inch CM stormdrain pipe through the levee, 8.0 feet below the crown. Flap gate on the waterward end. Brass cap No. 90 BM on headwall on the landward side. (USACE-1967). This entry matches the Drainage or Irrigation Structure referenced in O&M manual (HLM 5.05). FS Date: 4/8/2014

Flapgate and headwall visible at WS toe.

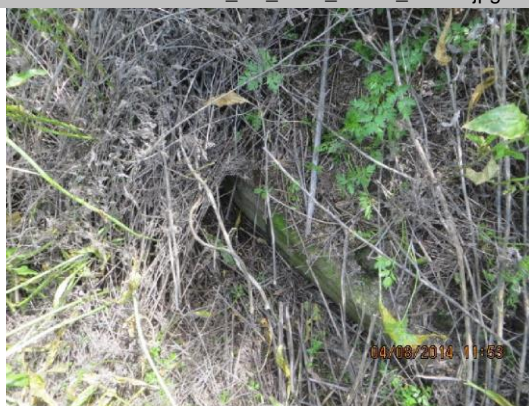
Photo 2 of 2 : UCIP\_SP\_2017\_39151\_60741.jpg

Comment Code					
Inspector Comment					
FS_ID:39151 DS_ID:19611 EP_NO: N/A Repair Type: Non-Urgent Crossing Status: Found UCIP Comments: Dense vegetation limits the inspector's visibility to identify signs of pipe failure (leaks) along waterward and landward slopes. Recommend removing vegetation along pipe alignment to conduct proper inspection of structure and appurtenances. Landward side filled in with soil. Need to contact owner. If crossing is no longer used need to coordinate with CVFPB for proper abandonment. FIELD_STRUCT_DESC: 24-inch CM stormdrain pipe through the levee, 8.6 feet below the crown. Flap gate on the waterward end. Brass cap No. 90 BM on headwall on the landward side. (USACE-1967). This entry matches the Drainage or Irrigation Structure referenced in O&M manual (HLM 5.95). FS Date: 4/8/2014

Top of concrete headwall just visible on LS toe.

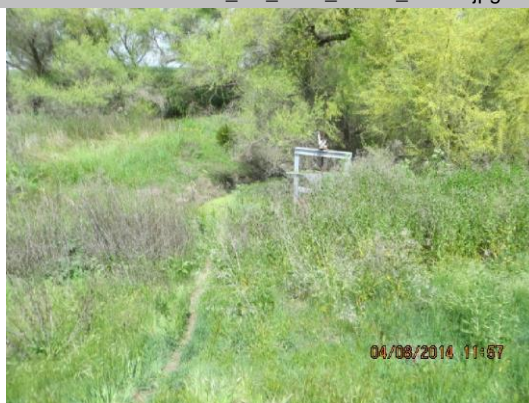
Photo 1 of 3 : UCIP\_SP\_2017\_39152\_60745.jpg

Comment Code					
Inspector Comment					
FS_ID:39152 DS_ID:19612 EP_NO: N/A Repair Type: Non-Urgent Crossing Status: Found UCIP Comments: Dense vegetation limits the inspector's visibility to identify signs of pipe failure (leaks) along waterward and landward slopes. Recommend removing vegetation along pipe alignment to conduct proper inspection of structure and appurtenances. Pipe completely blocked by soil on LS toe due to animal activity. Slide gate blocked open. FIELD_STRUCT_DESC: 48-inch CM pipe through the levee, 13.1 feet below the crown. Walkway to slidegate on LS toe at concrete headwall. Flap gate at concrete headwall on the WS toe. Brass cap No. 90 BM on headwall on the landward side. (USACE-1967). Pipe crosses levee at an angle to levee alignment. This entry matches the Drainage or Irrigation Structure referenced in O&M manual (HLM 6.13). FS Date: 4/8/2014

Slidegate at LS toe.

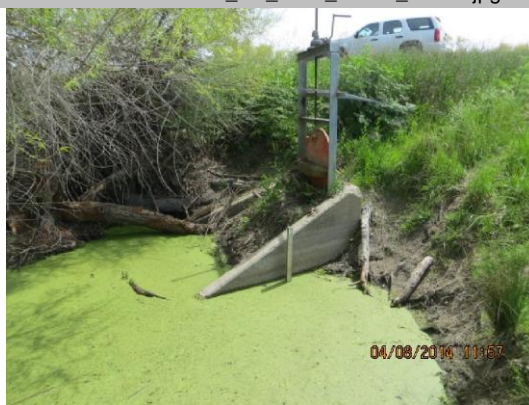
Photo 2 of 3 : UCIP\_SP\_2017\_39152\_60744.jpg

Pipe, concrete headwall, slidegate, and metal walkway on LS toe.

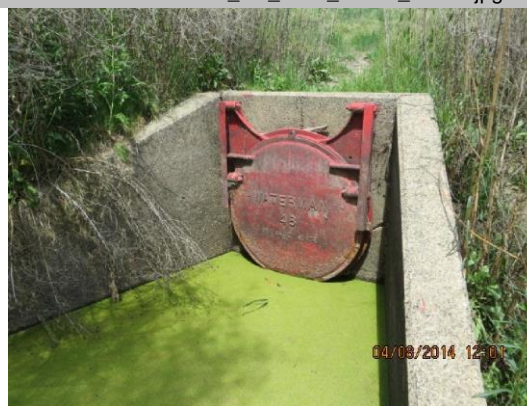
Photo 3 of 3 : UCIP\_SP\_2017\_39152\_60743.jpg

FS\_ID:39152  
DS\_ID:19612  
EP\_NO: N/A  
Repair Type: Non-Urgent  
Crossing Status: Found  
UCIP Comments: Dense vegetation limits the inspector's visibility to identify signs of pipe failure (leaks) along waterward and landward slopes. Recommend removing vegetation along pipe alignment to conduct proper inspection of structure and appurtenances. Pipe completely blocked by soil on LS toe due to animal activity. Slide gate blocked open.  
FIELD\_STRUCT\_DESC: 48-inch CM pipe through the levee, 13.1 feet below the crown. Walkway to slidegate on LS toe at concrete headwall. Flap gate at concrete headwall on the WS toe. Brass cap No. 90 BM on headwall on the landward side. (USACE-1967). Pipe crosses levee at an angle to levee alignment. This entry matches the Drainage or Irrigation Structure referenced in O&M manual (HLM 6.13).  
FS Date: 4/8/2014

Flapgate on concrete headwall at WS toe.

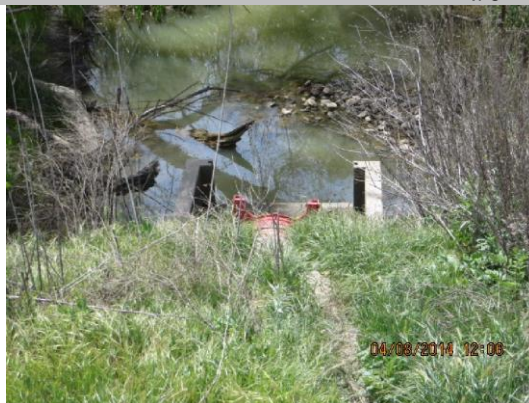
Photo 1 of 3 : UCIP\_SP\_2017\_39154\_60762.jpg

Comment Code					
Inspector Comment					
FS_ID:39154 DS_ID:19613 EP_NO: N/A Repair Type: Non-Urgent Crossing Status: Found UCIP Comments: Dense vegetation limits the inspector's visibility to identify signs of pipe failure (leaks) along the slope. Recommend removing vegetation along pipe alignment to conduct proper inspection of structure and appurtenances. FIELD_STRUCT_DESC: 24-inch CM stormdrain pipe through the levee, 9.5 feet below the crown. Flap gate on the waterward end. Slide gate on the landward end next to 48-inch concrete riser with walkway over its top. Brass cap No. 90 BM on headwall on the landward side. (USACE-1967). This entry matches the Drainage or Irrigation Structure referenced in O&M manual (HLM 6.40). FS Date: 4/8/2014

Pipe, flapgate, and concrete headwall on WS toe.

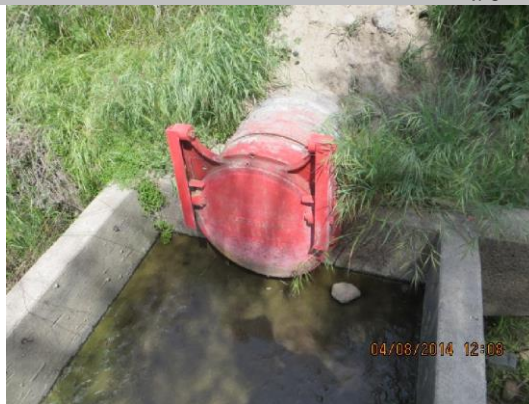
Photo 2 of 3 : UCIP\_SP\_2017\_39154\_60760.jpg

Pipe, flapgate, and concrete headwall on WS toe.

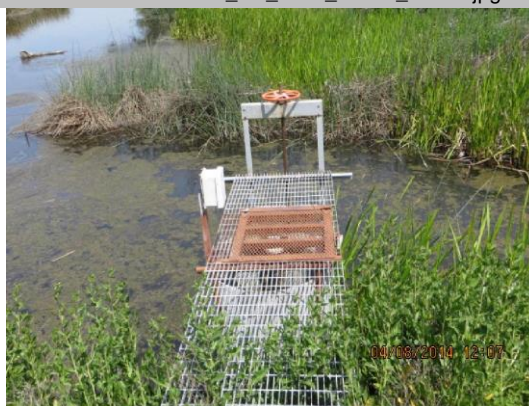
Photo 3 of 3 : UCIP\_SP\_2017\_39154\_60761.jpg

Comment Code					
Inspector Comment					
FS_ID:39154 DS_ID:19613 EP_NO: N/A Repair Type: Non-Urgent Crossing Status: Found UCIP Comments: Dense vegetation limits the inspector's visibility to identify signs of pipe failure (leaks) along the slope. Recommend removing vegetation along pipe alignment to conduct proper inspection of structure and appurtenances. FIELD_STRUCT_DESC: 24-inch CM stormdrain pipe through the levee, 9.5 feet below the crown. Flap gate on the waterward end. Slide gate on the landward end next to 48-inch concrete riser with walkway over its top. Brass cap No. 90 BM on headwall on the landward side. (USACE-1967). This entry matches the Drainage or Irrigation Structure referenced in O&M manual (HLM 6.40). FS Date: 4/8/2014

Metal walkway over concrete standpipe next to slide gate on LS toe.

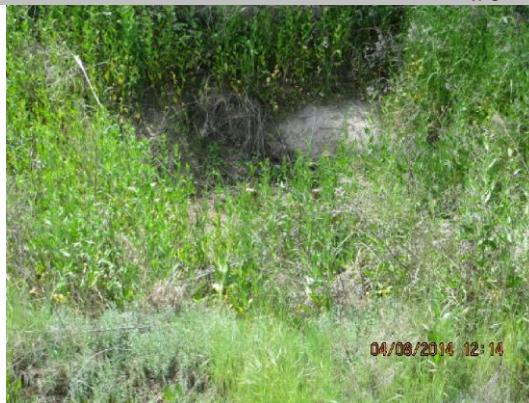
Photo 1 of 3 : UCIP\_SP\_2017\_49962\_60764.jpg

Comment Code					
Inspector Comment					
FS_ID:49962 DS_ID:19614 EP_NO: N/A Repair Type: Non-Urgent Crossing Status: Found UCIP Comments: 7/19/2016 Same as previous inspection. Outlet and inlet are under water. (DWR UCIP - omagana)4/08/2014 Flapgate blocked by sedimentation at WS toe. Dense vegetation limits the inspector's visibility to identify signs of pipe failure (leaks) along the slope. Recommend removing vegetation along pipe alignment to conduct proper inspection of structure and appurtenances. Also recommend clearing vegetation from both waterward and landward toe. (DWR UCIP - omagana) FIELD_STRUCT_DESC: 24-inch corrugated metal drainage pipe through the levee, 9.8 feet below the crown. Wooden fence around 4-foot by 4-foot drop inlet located on the landside (LS) toe. Flap gate located on the waterside (WS) end. Brass cap No. 90 BM on headwall located on the LS. [Additional Reference(s): DWR Levee Log, 2002. USACE San Joaquin O&M Manuals: Unit No. 601, 1967, (HLM 6.64), Unit No. 601 Part I, 1967 (Amended in 1978), Unit No. 601 Part II, 1969, and Unit No. 601 Part III, 1969] FS Date: 7/19/2016

Pipe and flapgate visible on WS toe.

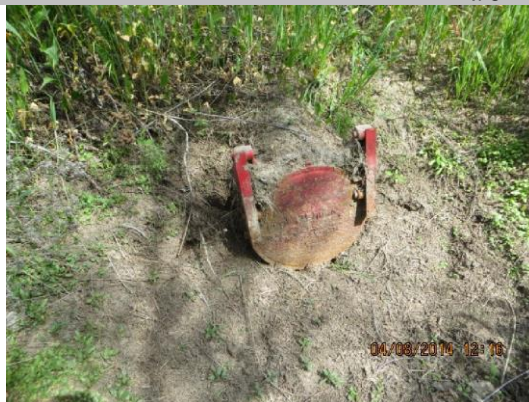
Photo 2 of 3 : UCIP\_SP\_2017\_49962\_60766.jpg

Pipe and flapgate visible at WS toe. Flapgate blocked by sedimentation on WS toe.

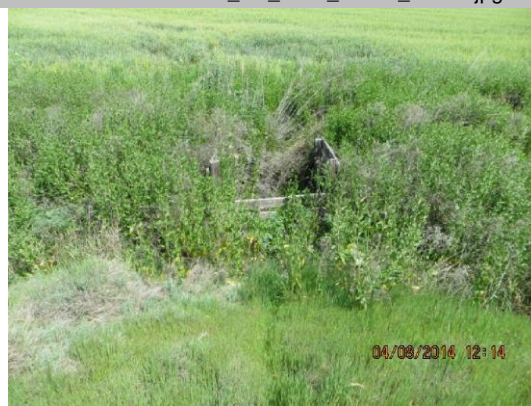
Photo 3 of 3 : UCIP\_SP\_2017\_49962\_60765.jpg

Item	DWR UCIP LMA Responsibility			37.303815 °		37.303815 °
				-120.891955 °		-120.891955 °
DWR ID						
Comment Code						
Inspector Comment						
FS_ID:49962 DS_ID:19614 EP_NO: N/A Repair Type: Non-Urgent Crossing Status: Found UCIP Comments: 7/19/2016 Same as previous inspection. Outlet and inlet are under water. (DWR UCIP - omagana)4/08/2014 Flapgate blocked by sedimentation at WS toe. Dense vegetation limits the inspector's visibility to identify signs of pipe failure (leaks) along the slope. Recommend removing vegetation along pipe alignment to conduct proper inspection of structure and appurtenances. Also recommend clearing vegetation from both waterward and landward toe. (DWR UCIP - omagana) FIELD_STRUCT_DESC: 24-inch corrugated metal drainage pipe through the levee, 9.8 feet below the crown. Wooden fence around 4-foot by 4-foot drop inlet located on the landside (LS) toe. Flap gate located on the waterside (WS) end. Brass cap No. 90 BM on headwall located on the LS. [Additional Reference(s): DWR Levee Log, 2002. USACE San Joaquin O&M Manuals: Unit No. 601, 1967, (HLM 6.64), Unit No. 601 Part I, 1967 (Amended in 1978), Unit No. 601 Part II, 1969, and Unit No. 601 Part III, 1969] FS Date: 7/19/2016

Wooden barrier around drop inlet on LS toe. Excess vegetation.

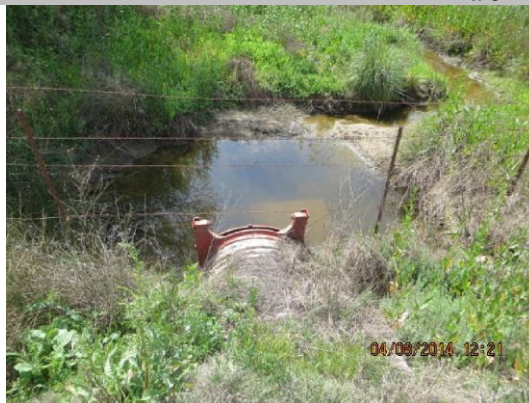
Photo 1 of 3 : UCIP\_SP\_2017\_50077\_60768.jpg

Comment Code					
Inspector Comment					
FS_ID:50077 DS_ID:19615 EP_NO: N/A Repair Type: Non-Urgent Crossing Status: Found UCIP Comments: 7/19/2016 Potential LS slope damage--difficult to determine due to dense vegetation. Limited access on WS toe due to wire fence. (DWR UCIP - omagana)4/08/2014 Slide gate blocked by debris at LS toe. Flapgate won't close because of debris. Dense vegetation limits the inspector's visibility to identify signs of pipe failure (leaks) along the slope. Recommend removing vegetation along pipe alignment to conduct proper inspection of structure and appurtenances. (DWR UCIP - omagana) FIELD_STRUCT_DESC: 36-inch corrugated metal drainage pipe through the levee, 10.3 feet below the crown. Slidegate located on landside (LS) toe and a flap gate located on the waterside (WS) end. Brass cap No. 90 BM is located on headwall on the LS. [Additional Reference(s): DWR Levee Log, 2002. USACE San Joaquin O&M Manuals: Unit No. 601, 1967, (HLM 6.90), Unit No. 601 Part I, 1967 (Amended in 1978), Unit No. 601 Part II, 1969, and Unit No. 601 Part III, 1969] FS Date: 7/19/2016

Pipe, headwall, and flapgate on WS toe.

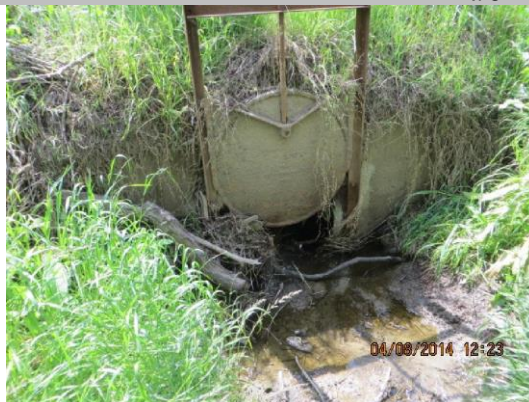
Photo 2 of 3 : UCIP\_SP\_2017\_50077\_60767.jpg

Pipe, concrete headwall, and slidegate on LS toe. Debris blocking closure of slidegate.

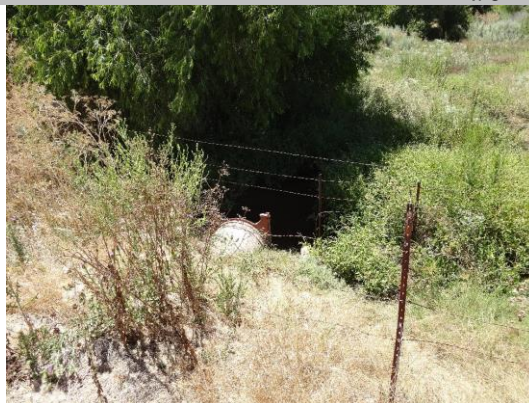
Photo 3 of 3 : UCIP\_SP\_2017\_50077\_75470.jpg

Comment Code					
Inspector Comment					
FS_ID:50077 DS_ID:19615 EP_NO: N/A Repair Type: Non-Urgent Crossing Status: Found UCIP Comments: 7/19/2016 Potential LS slope damage--difficult to determine due to dense vegetation. Limited access on WS toe due to wire fence. (DWR UCIP - omagana)4/08/2014 Slide gate blocked by debris at LS toe. Flapgate won't close because of debris. Dense vegetation limits the inspector's visibility to identify signs of pipe failure (leaks) along the slope. Recommend removing vegetation along pipe alignment to conduct proper inspection of structure and appurtenances. (DWR UCIP - omagana) FIELD_STRUCT_DESC: 36-inch corrugated metal drainage pipe through the levee, 10.3 feet below the crown. Slidegate located on landside (LS) toe and a flap gate located on the waterside (WS) end. Brass cap No. 90 BM is located on headwall on the LS. [Additional Reference(s): DWR Levee Log, 2002. USACE San Joaquin O&M Manuals: Unit No. 601, 1967, (HLM 6.90), Unit No. 601 Part I, 1967 (Amended in 1978), Unit No. 601 Part II, 1969, and Unit No. 601 Part III, 1969] FS Date: 7/19/2016

View of WS--fence limits access to flap gate.

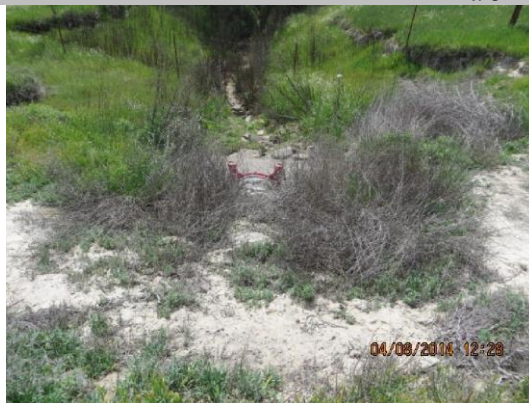
Photo 1 of 3 : UCIP\_SP\_2017\_42851\_60770.jpg

Comment Code					
Inspector Comment					
FS_ID:42851					
DS_ID:19616					
EP_NO: N/A					
Repair Type: Non-Urgent					
Crossing Status: Found					
UCIP Comments: Pipe failing and corroded through at LS toe. Need to contact owner to determine status of crossing. Also dense vegetation limits the inspector's visibility to identify signs of pipe failure (leaks) along the landward slope. Recommend removing vegetation along pipe alignment to conduct proper inspection of structure.					
FIELD_STRUCT_DESC: 24-inch CM stormdrain pipe through the levee, 5.1 feet below the crown. Flap gate on the waterward end. Brass cap No. 90 BM on headwall on the landward side. (USACE-1967). This entry matches the Drainage or Irrigation Structure referenced in O&M manual (HLM 7.21).					
FS Date: 4/8/2014

Pipe, concrete headwall, and flapgate on WS toe.

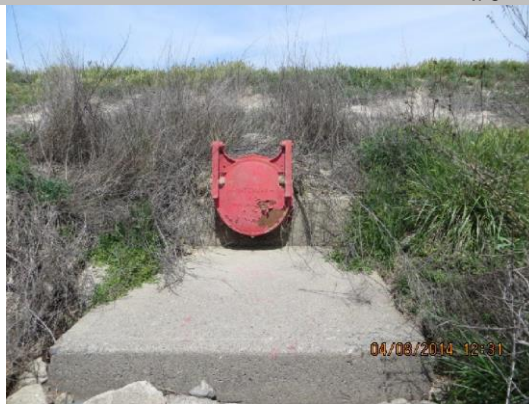
Photo 2 of 3 : UCIP\_SP\_2017\_42851\_60772.jpg

Flapgate and concrete headwall on WS toe.

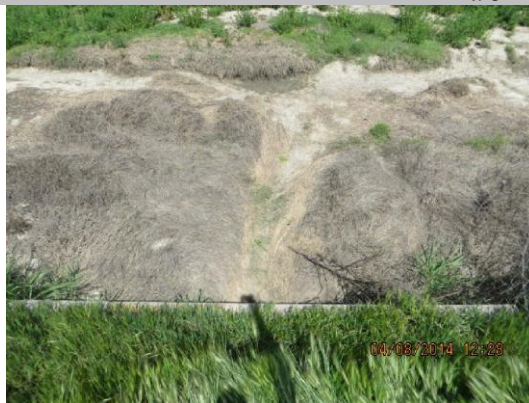
Photo 3 of 3 : UCIP\_SP\_2017\_42851\_60771.jpg

Item	DWR UCIP LMA Responsibility			37.300055 °	37.300055 °	
				-120.882939 °	-120.882939 °	
DWR ID						
Comment Code						
Inspector Comment						
FS_ID:42851						
DS_ID:19616						
EP_NO: N/A						
Repair Type: Non-Urgent						
Crossing Status: Found						
UCIP Comments: Pipe failing and corroded through at LS toe. Need to contact owner to determine status of crossing. Also dense vegetation limits the inspector's visibility to identify signs of pipe failure (leaks) along the landward slope. Recommend removing vegetation along pipe alignment to conduct proper inspection of structure.						
FIELD_STRUCT_DESC: 24-inch CM stormdrain pipe through the levee, 5.1 feet below the crown. Flap gate on the waterward end. Brass cap No. 90 BM on headwall on the landward side. (USACE-1967). This entry matches the Drainage or Irrigation Structure referenced in O&M manual (HLM 7.21).						
FS Date: 4/8/2014

Pipe and Concrete headwall visible on LS toe.

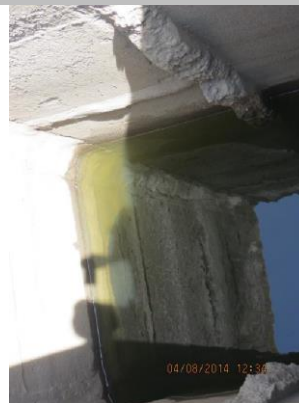
Photo 1 of 3 : UCIP\_SP\_2017\_39160\_60776.jpg

FS\_ID:39160  
DS\_ID:19617  
EP\_NO: 4425  
Repair Type: Non-Urgent  
Crossing Status: Found  
UCIP Comments: Recommend contacting owner to determine status of crossing. No pump was found on waterward side (riverbank). If crossing is no longer used need to coordinate with CVFPB for proper abandonment.  
FIELD\_STRUCT\_DESC: 24-inch steel irrigation pipe through the levee, 13.6 feet below the crown. Pipe encased in 6-inches of concrete through levee. 5'X7' Concrete distribution box on the waterward side. 20-inch concrete standpipe at LS toe. Pump on the riverbank, accessible by walkway platform (Pump not found). Concrete cutoff walls around pipe in line with levee shoulders. Pipe extends to 36-inch concrete pipes on both sides of levee. (Permit No. 4425-1965)  
FS Date: 4/8/2014

Pipe visible under water in concrete box riser on WS toe.

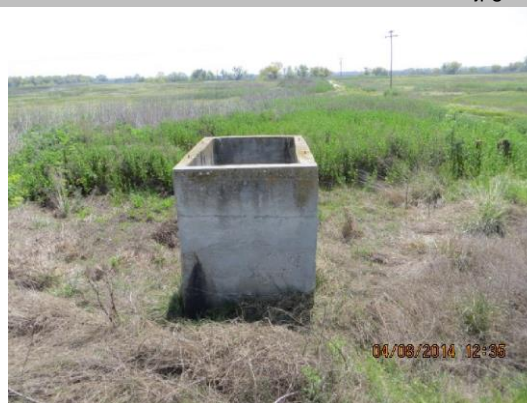
Photo 2 of 3 : UCIP\_SP\_2017\_39160\_60775.jpg

5'X7' concrete box riser on WS toe.

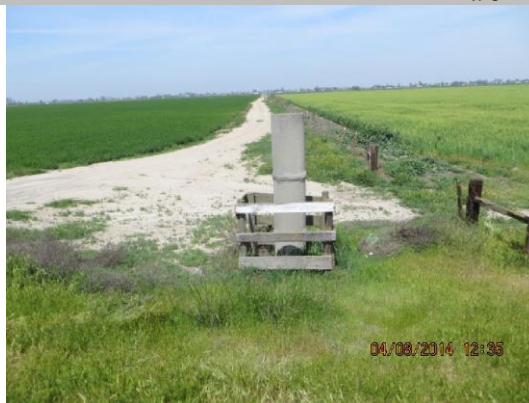
Photo 3 of 3 : UCIP\_SP\_2017\_39160\_60774.jpg

Item	DWR UCIP Field Study			37.299931 °		37.299931 °
				-120.880947 °		-120.880947 °
DWR ID						
Comment Code						
Inspector Comment						
FS_ID:39160 DS_ID:19617 EP_NO: 4425 Repair Type: Non-Urgent Crossing Status: Found UCIP Comments: Recommend contacting owner to determine status of crossing. No pump was found on waterward side (riverbank). If crossing is no longer used need to coordinate with CVFPB for proper abandonment. FIELD_STRUCT_DESC: 24-inch steel irrigation pipe through the levee, 13.6 feet below the crown. Pipe encased in 6-inches of concrete through levee. 5'X7' Concrete distribution box on the waterward side. 20-inch concrete standpipe at LS toe. Pump on the riverbank, accessible by walkway platform (Pump not found). Concrete cutoff walls around pipe in line with levee shoulders. Pipe extends to 36-inch concrete pipes on both sides of levee. (Permit No. 4425-1965) FS Date: 4/8/2014

20-inch concrete standpipe off LS toe.

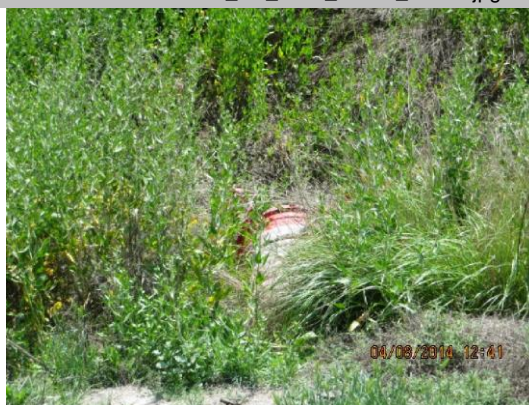
Photo 1 of 3 : UCIP\_SP\_2017\_39161\_60778.jpg

Comment Code					
Inspector Comment					
FS_ID:39161 DS_ID:19618 EP_NO: N/A Repair Type: Non-Urgent Crossing Status: Found UCIP Comments: Dense vegetation limits the inspector's visibility to identify signs of pipe failure (leaks) along the slope. Recommend removing vegetation along pipe alignment to conduct proper inspection of structure and appurtenances. FIELD_STRUCT_DESC: 24-inch CM stormdrain pipe through the levee, 8.0 feet below the crown. Flap gate on the waterward end. Brass cap No. 80 BM on headwall on the landward side. (USACE-1967). This entry matches the Drainage or Irrigation Structure referenced in O&M manual (HLM 7.46). FS Date: 4/8/2014

Pipe and flapgate visible on WS toe.

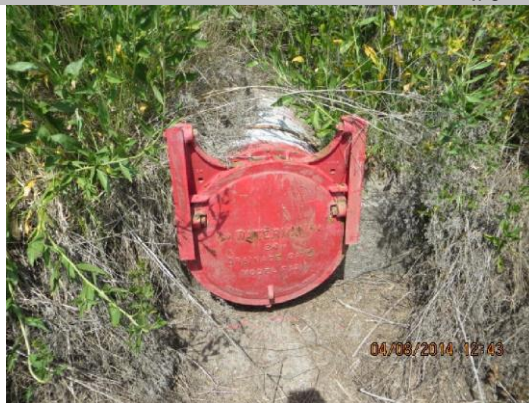
Photo 2 of 3 : UCIP\_SP\_2017\_39161\_60780.jpg

Item	DWR UCIP LMA Responsibility			37.299817 °		37.299817 °
				-120.878519 °		-120.878519 °
DWR ID						
Comment Code						
Inspector Comment						
FS_ID:39161 DS_ID:19618 EP_NO: N/A Repair Type: Non-Urgent Crossing Status: Found UCIP Comments: Dense vegetation limits the inspector's visibility to identify signs of pipe failure (leaks) along the slope. Recommend removing vegetation along pipe alignment to conduct proper inspection of structure and appurtenances. FIELD_STRUCT_DESC: 24-inch CM stormdrain pipe through the levee, 8.0 feet below the crown. Flap gate on the waterward end. Brass cap No. 80 BM on headwall on the landward side. (USACE-1967). This entry matches the Drainage or Irrigation Structure referenced in O&M manual (HLM 7.46). FS Date: 4/8/2014

Pipe and flapgate visible on WS toe.

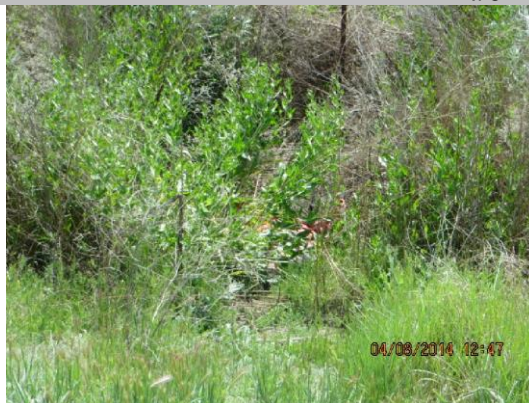
Photo 1 of 3 : UCIP\_SP\_2017\_39243\_60842.jpg

LM Start	7.65	Rating **	M	Issue No.	1217
LM End	7.65	Issue Type +	Ma	Location *	WS
Category	Supplemental			GPS Latitude/Longitude	
				Start	End
Item	DWR UCIP LMA Responsibility			37.299211 °	37.299211 °
				-120.874415 °	-120.874415 °
DWR ID					
Comment Code					
Inspector Comment					
FS_ID:39243 DS_ID:19619 EP_NO: N/A Repair Type: Non-Urgent Crossing Status: Found UCIP Comments: Dense vegetation limits the inspector's visibility to identify signs of pipe failure (leaks) along the slope. Recommend removing vegetation along pipe alignment to conduct proper inspection of structure. FIELD_STRUCT_DESC: 24-inch CM pipe through the levee, 10.0 feet below the crown. Flap gate on the waterward end. Brass cap No. 80 BM on headwall on the landward side. (USACE-1967). This entry matches the Drainage or Irrigation Structure referenced in O&M manual (HLM 7.69). FS Date: 4/8/2014

Flapgate and headwall at WS toe. Heavy vegetation on slopes.

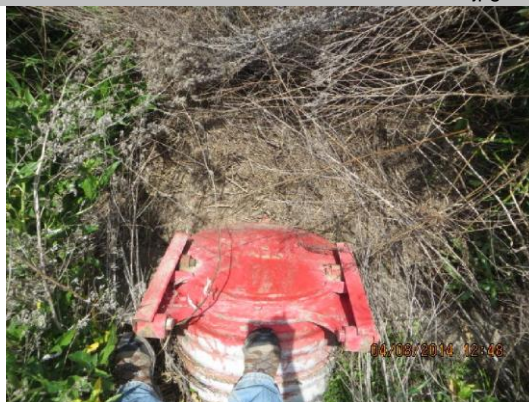
Photo 2 of 3 : UCIP\_SP\_2017\_39243\_60840.jpg

Flapgate and headwall at WS toe.

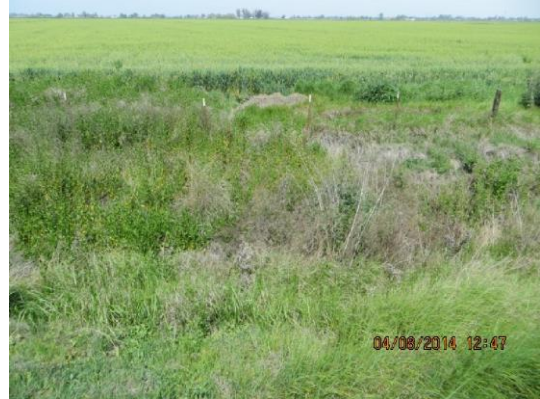
Photo 3 of 3 : UCIP\_SP\_2017\_39243\_60841.jpg

Item	DWR UCIP LMA Responsibility			37.299211 °		37.299211 °
				-120.874415 °		-120.874415 °
DWR ID						
Comment Code						
Inspector Comment						
FS_ID:39243						
DS_ID:19619						
EP_NO: N/A						
Repair Type: Non-Urgent						
Crossing Status: Found						
UCIP Comments: Dense vegetation limits the inspector's visibility to identify signs of pipe failure (leaks) along the slope. Recommend removing vegetation along pipe alignment to conduct proper inspection of structure.						
FIELD_STRUCT_DESC: 24-inch CM pipe through the levee, 10.0 feet below the crown. Flap gate on the waterward end. Brass cap No. 80 BM on headwall on the landward side. (USACE-1967). This entry matches the Drainage or Irrigation Structure referenced in O&M manual (HLM 7.69).						
FS Date: 4/8/2014

Concrete headwall at LS toe. Heavy vegetation on both slopes.

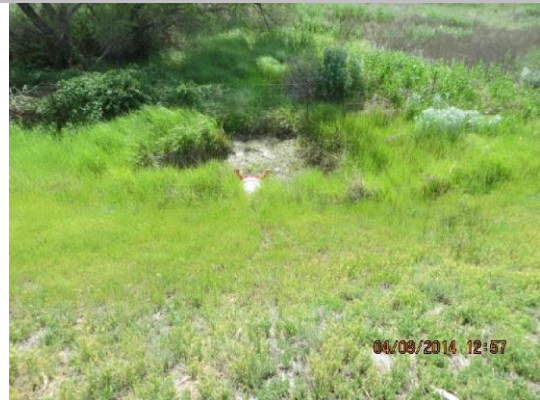
Photo 1 of 3 : UCIP\_SP\_2017\_39244\_60844.jpg

LM Start	8.03	Rating **	M	Issue No.	1218
LM End	8.03	Issue Type +	Ma	Location *	WS
Category	Supplemental			GPS Latitude/Longitude	
				Start	End
Item	DWR UCIP LMA Responsibility			37.298711 °	37.298711 °
				-120.867756 °	-120.867756 °
DWR ID					
Comment Code					
Inspector Comment					
FS_ID:39244 DS_ID:19620 EP_NO: N/A Repair Type: Non-Urgent Crossing Status: Found UCIP Comments: Dense vegetation limits the inspector's visibility to identify signs of pipe failure (leaks) along the slope. Recommend removing vegetation along pipe alignment to conduct proper inspection of structure. FIELD_STRUCT_DESC: 24-inch CM stormdrain pipe through the levee, 8.0 feet below the crown. Flap gate on the waterward end. Brass cap No. 80 BM on headwall on the landward side. (USACE-1967). This entry matches the Drainage or Irrigation Structure referenced in O&M manual (HLM 8.07). FS Date: 4/9/2014

Pipe, Headwall, and flapgate at WS toe.

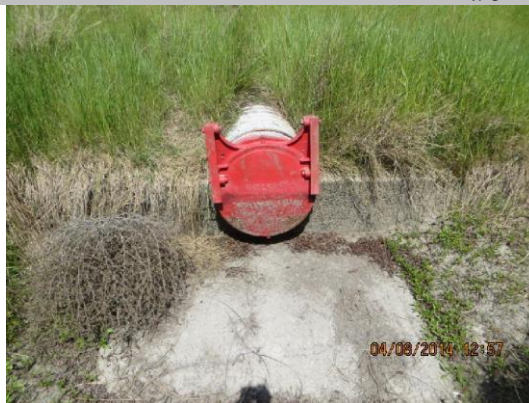
Photo 2 of 3 : UCIP\_SP\_2017\_39244\_60847.jpg

Item	DWR UCIP LMA Responsibility			37.298711 °	37.298711 °	
				-120.867756 °	-120.867756 °	
DWR ID						
Comment Code						
Inspector Comment						
FS_ID:39244						
DS_ID:19620						
EP_NO: N/A						
Repair Type: Non-Urgent						
Crossing Status: Found						
UCIP Comments: Dense vegetation limits the inspector's visibility to						
identify signs of pipe failure (leaks) along the slope. Recommend						
removing vegetation along pipe alignment to conduct proper inspection						
of structure.						
FIELD_STRUCT_DESC: 24-inch CM stormdrain pipe through the levee,

Pipe, Headwall, and flapgate at WS toe.

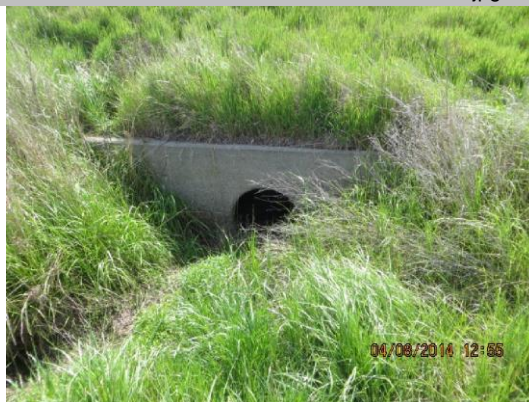
Photo 3 of 3 : UCIP\_SP\_2017\_39244\_60846.jpg

Pipe and concrete headwall on LS toe.

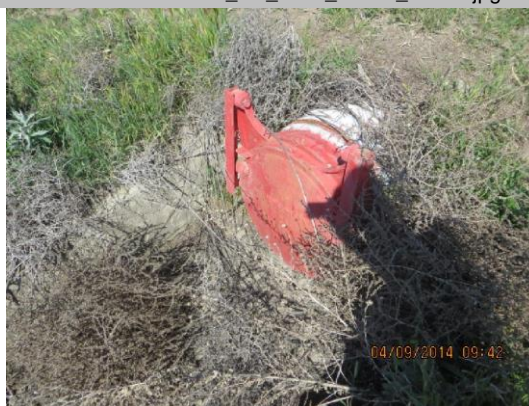
Photo 2 of 3 : UCIP\_SP\_2017\_39246\_60855.jpg

LM Start	8.57	Rating **	A/W	Issue No.	1220 (cont)
LM End	8.57	Issue Type +	Ma	Location *	WS
Category	Supplemental			GPS Latitude/Longitude	
				Start	End
Item	DWR UCIP LMA Responsibility			37.296552 °	37.296552 °
				-120.858596 °	-120.858596 °
DWR ID					
Comment Code					
Inspector Comment					
FS_ID:39246					
DS_ID:19622					
EP_NO: N/A					
Repair Type: No Action Needed					
Crossing Status: Found					
UCIP Comments:					
FIELD_STRUCT_DESC: 24-inch CM stormdrain pipe through the levee, 9.0 feet below the crown. Flap gate on waterward end. Brass cap No. 80 BM on headwall on the landward side. (USACE-1967). This entry matches the Drainage or Irrigation Structure referenced in O&M manual (HLM 8.61).					
FS Date: 4/9/2014

Pipe, Flapgate, and headwall on WS toe.

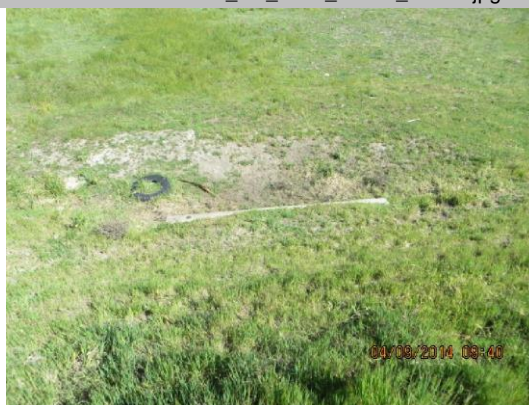
Photo 3 of 3 : UCIP\_SP\_2017\_39246\_60853.jpg

Pipe and headwall at LS toe.

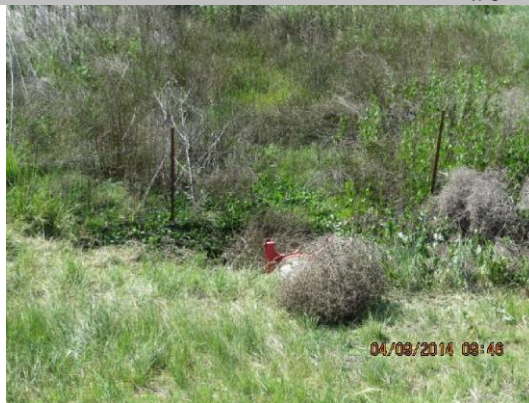
Photo 1 of 3 : UCIP\_SP\_2017\_39247\_60859.jpg

LM Start	8.89	Rating **	M	Issue No.	1221
LM End	8.89	Issue Type +	Ma	Location *	WS
Category	Supplemental			GPS Latitude/Longitude	
				Start	End
Item	DWR UCIP LMA Responsibility			37.297296 °	37.297296 °
				-120.852871 °	-120.852871 °
DWR ID					
Comment Code					
Inspector Comment					
FS_ID:39247 DS_ID:19623 EP_NO: N/A Repair Type: Non-Urgent Crossing Status: Found UCIP Comments: Dense vegetation limits the inspector's visibility to identify signs of pipe failure (leaks) along the slope. Recommend removing vegetation along pipe alignment to conduct proper inspection of structure. FIELD_STRUCT_DESC: 24-inch CM stormdrain pipe through the levee, 9.1 feet below the crown. Flap gate on the waterward end. Brass cap No. 80 BM on headwall on the landward side. (USACE-1967). This entry matches the Drainage or Irrigation Structure referenced in O&M manual (HLM 8.93). FS Date: 4/9/2014

Pipe, flapgate, and headwall on WS toe.

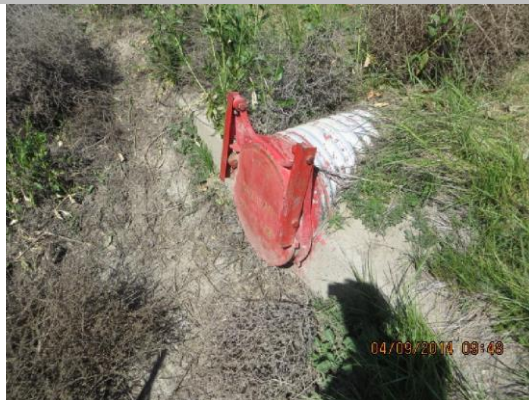
Photo 2 of 3 : UCIP\_SP\_2017\_39247\_60860.jpg

Pipe, flapgate, and headwall on WS toe.

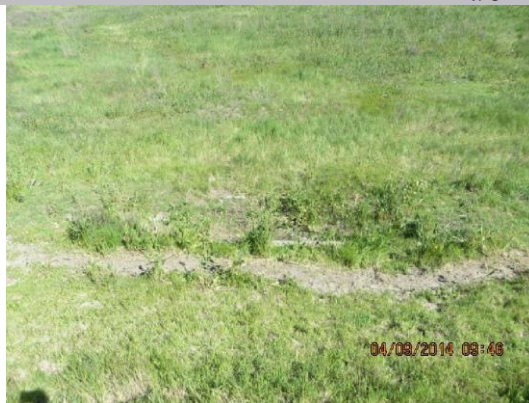
Photo 3 of 3 : UCIP\_SP\_2017\_39247\_60858.jpg

Item	DWR UCIP LMA Responsibility			37.297296 °		37.297296 °
				-120.852871 °		-120.852871 °
DWR ID						
Comment Code						
Inspector Comment						
FS_ID:39247 DS_ID:19623 EP_NO: N/A Repair Type: Non-Urgent Crossing Status: Found UCIP Comments: Dense vegetation limits the inspector's visibility to identify signs of pipe failure (leaks) along the slope. Recommend removing vegetation along pipe alignment to conduct proper inspection of structure. FIELD_STRUCT_DESC: 24-inch CM stormdrain pipe through the levee, 9.1 feet below the crown. Flap gate on the waterward end. Brass cap No. 80 BM on headwall on the landward side. (USACE-1967). This entry matches the Drainage or Irrigation Structure referenced in O&M manual (HLM 8.93). FS Date: 4/9/2014

Pipe and headwall visible on LS toe.

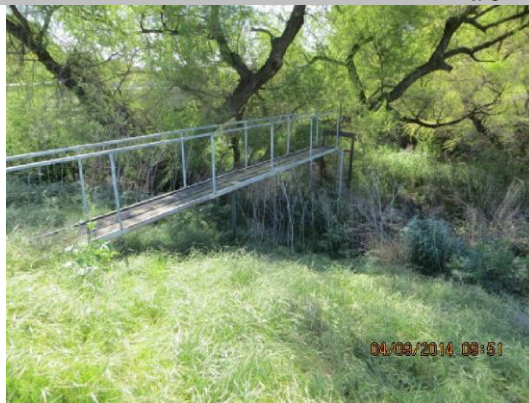
Photo 1 of 3 : UCIP\_SP\_2017\_49964\_60864.jpg

FS\_ID:49964  
DS\_ID:19624  
EP\_NO: 12156  
Repair Type: Urgent  
Crossing Status: Found  
UCIP Comments: 7/19/2016 same as previous inspection--pipe rusted through. Sediment visible inside LS pipe; walkway wood panels have dry rot and appears to be unsafe to use. (DWR UCIP - omagana)4/09/2014 Slide gate rusted through and open on WS toe. Inlet appears to be obscured or covered in soil at LS toe. Also dense vegetation on waterward and landward sides. Need to contact owner to contact CVFPB to address issue. (DWR UCIP - omagana)  
FIELD\_STRUCT\_DESC: 26-inch steel pipe sleeved inside 30-inch concrete drainage through the levee, 7.3 feet below the crown. Annular gap grouted between 26-inch steel pipe and 30-inch concrete pipe. Concrete wingwalls located on each side of pipe. Slide gate on discharge end with elevated walkway access located on waterside (WS). Two concrete cutoff walls are located on the center of levee. Concrete headwall (6-inch thick) located on discharge end of pipe-landside (LS). (Permit No. 12156, 1978 - Merquin County Water District; Permit No. 12156-A, 1978 - Merquin County Water District) [Additional Reference(s): DWR Levee Log, 2002]

Metal walkway to slidegate operator on WS toe.

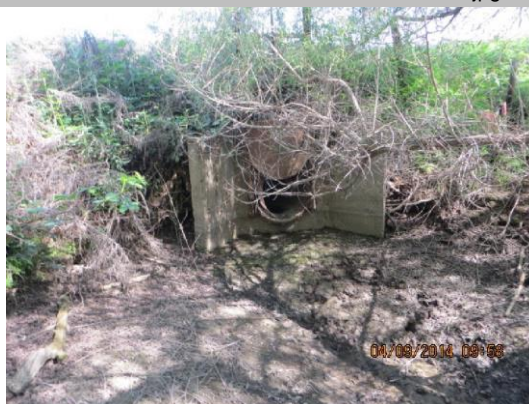
Photo 2 of 3 : UCIP\_SP\_2017\_49964\_60862.jpg

Slidegate and headwall at WS toe.

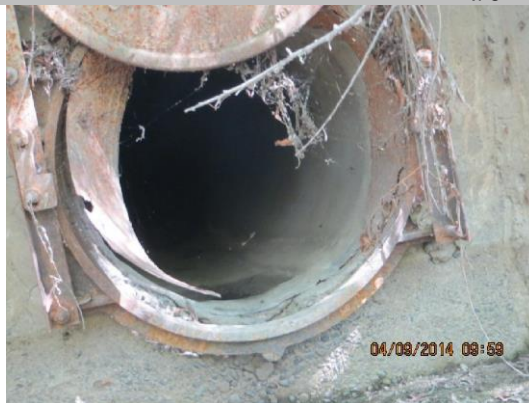
Photo 3 of 3 : UCIP\_SP\_2017\_49964\_60865.jpg

Comment Code					
Inspector Comment					
FS_ID:49964 DS_ID:19624 EP_NO: 12156 Repair Type: Urgent Crossing Status: Found UCIP Comments: 7/19/2016 same as previous inspection--pipe rusted through. Sediment visible inside LS pipe; walkway wood panels have dry rot and appears to be unsafe to use. (DWR UCIP - omagana)4/09/2014 Slide gate rusted through and open on WS toe. Inlet appears to be obscured or covered in soil at LS toe. Also dense vegetation on waterward and landward sides. Need to contact owner to contact CVFPB to address issue. (DWR UCIP - omagana) FIELD_STRUCT_DESC: 26-inch steel pipe sleeved inside 30-inch concrete drainage through the levee, 7.3 feet below the crown. Annular gap grouted between 26-inch steel pipe and 30-inch concrete pipe. Concrete wingwalls located on each side of pipe. Slide gate on discharge end with elevated walkway access located on waterside (WS). Two concrete cutoff walls are located on the center of levee. Concrete headwall (6-inch thick) located on discharge end of pipe-landside (LS). (Permit No. 12156, 1978 - Merquin County Water District; Permit No. 12156-A, 1978 - Merquin County Water District) [Additional Reference(s): DWR Levee Log, 2002] FS Date: 7/19/2016

Slidegate rusted through and open on WS toe.

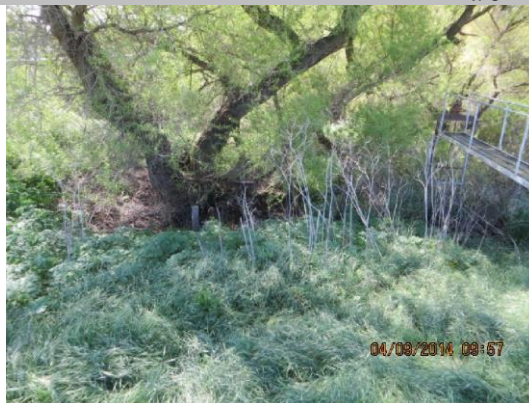
Photo 1 of 3 : UCIP\_SP\_2017\_39249\_60870.jpg

Comment Code					
Inspector Comment					
FS_ID:39249 DS_ID:19625 EP_NO: N/A Repair Type: Non-Urgent Crossing Status: Found UCIP Comments: Dense vegetation limits the inspector's visibility to identify signs of pipe failure (leaks) along the slope. Recommend removing vegetation along pipe alignment to conduct proper inspection of structure. Some sediment buildup in pipe. FIELD_STRUCT_DESC: 36-inch CM stormdrain pipe through the levee, 10.0 feet below the crown. Flap gate on the waterward end. Brass cap No. 80 BM on headwall on the landward side. (USACE-1967). This entry matches the Drainage or Irrigation Structure referenced in O&M manual (HLM 9.00). FS Date: 4/9/2014

Pipe and flapgate visible on WS toe.

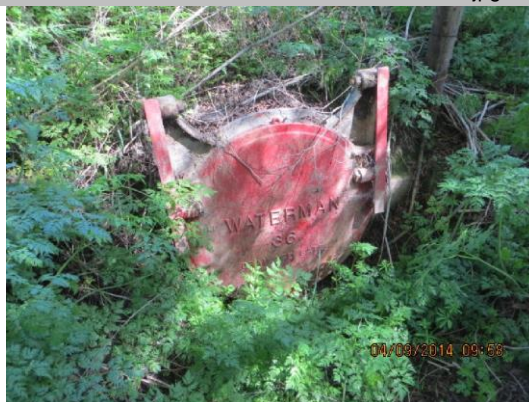
Photo 2 of 3 : UCIP\_SP\_2017\_39249\_60869.jpg

Pipe and flapgate visible on WS toe.

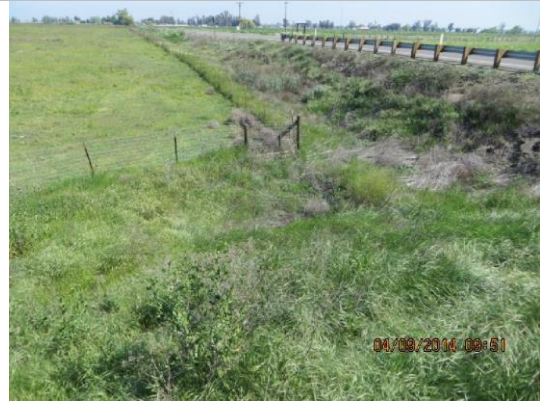
Photo 3 of 3 : UCIP\_SP\_2017\_39249\_60868.jpg

Item	DWR UCIP LMA Responsibility			37.297425 °		37.297425 °
				-120.851522 °		-120.851522 °
DWR ID						
Comment Code						
Inspector Comment						
FS_ID:39249 DS_ID:19625 EP_NO: N/A Repair Type: Non-Urgent Crossing Status: Found UCIP Comments: Dense vegetation limits the inspector's visibility to identify signs of pipe failure (leaks) along the slope. Recommend removing vegetation along pipe alignment to conduct proper inspection of structure. Some sediment buildup in pipe. FIELD_STRUCT_DESC: 36-inch CM stormdrain pipe through the levee, 10.0 feet below the crown. Flap gate on the waterward end. Brass cap No. 80 BM on headwall on the landward side. (USACE-1967). This entry matches the Drainage or Irrigation Structure referenced in O&M manual (HLM 9.00). FS Date: 4/9/2014

Pipe and headwall visible on LS toe.

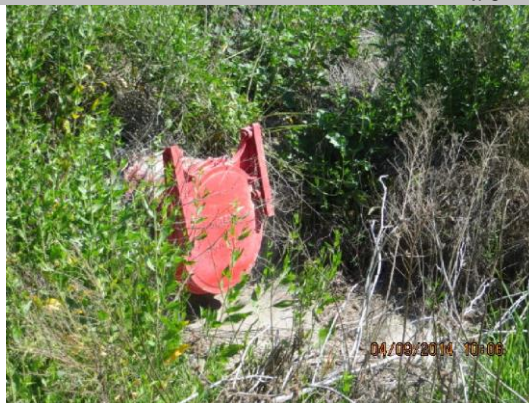
Photo 2 of 2 : UCIP\_SP\_2017\_39250\_60871.jpg

Item	DWR UCIP LMA Responsibility			37.297488 °		37.297488 °
				-120.851157 °		-120.851157 °
DWR ID						
Comment Code						
Inspector Comment						
FS_ID:39250 DS_ID:19626 EP_NO: N/A Repair Type: Non-Urgent Crossing Status: Found UCIP Comments: Dense vegetation limits the inspector's visibility to identify signs of pipe failure (leaks) along the slope. Recommend removing vegetation along pipe alignment to conduct proper inspection of structure. FIELD_STRUCT_DESC: 24-inch CM stormdrain pipe through the levee, 10.0 feet below the crown. Flap gate on the waterward end. Brass cap No. 80 BM on headwall on the landward side. (USACE-1967). This entry matches the Drainage or Irrigation Structure referenced in O&M manual (HLM 9.03). FS Date: 4/9/2014

Pipe, concrete headwall, and flapgate at WS toe.

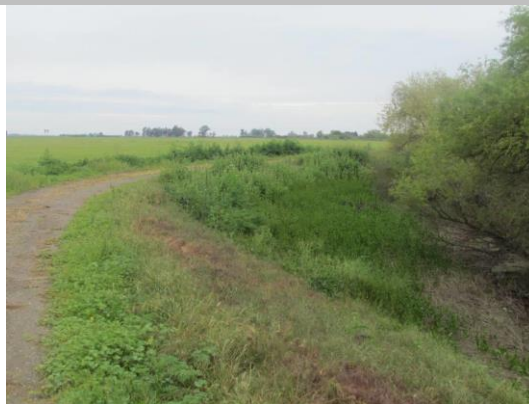
Photo 1 of 1 : SP\_2017\_NA0010\_118\_92\_20170424\_00279.jpg

LM Start	8.99	Rating **	U	Issue No.	92
LM End	9.43	Issue Type +	Ma	Location *	WS
Category	Earthen Levee			GPS Latitude/Longitude	
				Start	End
Item	Vegetation			37.297497 °	37.295310 °
				-120.851068 °	-120.843918 °
DWR ID	DWR_NA0010_01_s_2017_92				
Comment Code					
V2 : Remove the wild growth other than native grasses from the levee slopes.					
Inspector Comment

Looking southwest at dense veg on waterward slope.

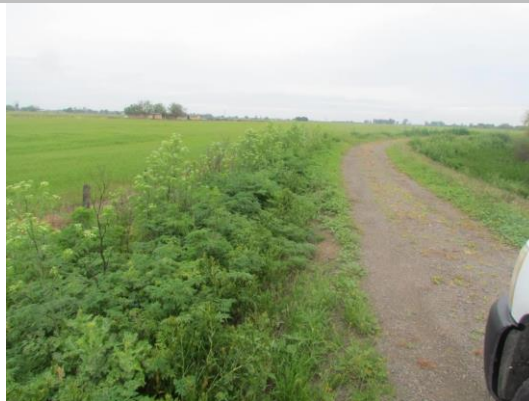
Photo 1 of 1 : SP\_2017\_NA0010\_118\_6\_20170424\_00280.jpg

LM Start	8.99	Rating **	U	Issue No.	6
LM End	9.61	Issue Type +	Ma	Location *	LS
Category	Earthen Levee			GPS Latitude/Longitude	
				Start	End
Item	Vegetation			37.297497 °	37.295138 °
				-120.851068 °	-120.840857 °
DWR ID	DWR_NA0010_01_s_2017_6				
Comment Code					
V2 : Remove the wild growth other than native grasses from the levee slopes.					
Inspector Comment

Looking south at dense veg on landward slope.

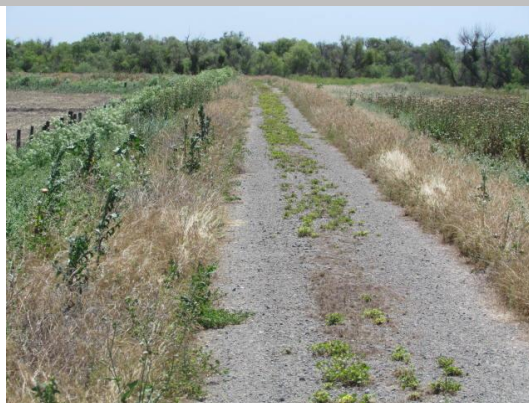
Photo 1 of 1 : SP\_2017\_NA0010\_118\_117\_20170417\_00028.jpg

LM Start	9.10	Rating **	M	Issue No.	117
LM End	9.78	Issue Type +	Ma	Location *	CR
Category	Earthen Levee			GPS Latitude/Longitude	
				Start	End
Item	Crown Surface / Depressions / Rutting			37.296725 °	37.293077 °
				-120.849438 °	-120.839170 °
DWR ID	DWR_NA0010_01_s_2012_117				
Comment Code					
C1 : Add appropriate material and re-grade the levee to bring the crown above the design elevation.					
Inspector Comment					
Control vegetation on levee crown.

Looking south at veg on levee crown.

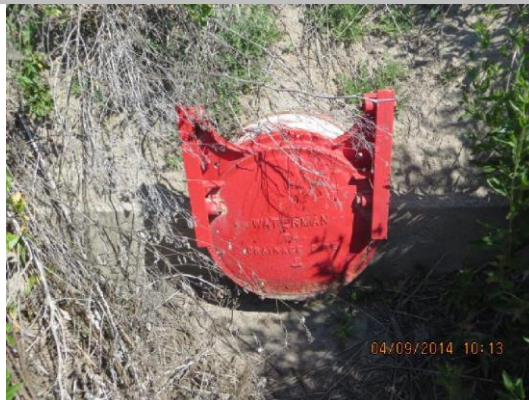
Photo 2 of 3 : UCIP\_SP\_2017\_39251\_60876.jpg

Headwall, Pipe, and flapgate on WS toe.
