**Flood Control Project Maintenance  
Levee Inspections**  
**LMA District Cover Sheet**  
**Spring 2017 Levee Inspection Results**

**Lower San Joaquin Levee District**

Waterway			Bank	Unit Miles
Unit No. 01 San Joaquin River			Right	22.52
	Spring (March - May)	Summer (June - August)	(September - November) Fall	Winter (December - February)
Unit Maintenance Rating (Fall Only)				
Date of Inspection	4/17/2017 - 4/20/2017			
DWR Inspector	Richard Willoughby			
Accompanied By

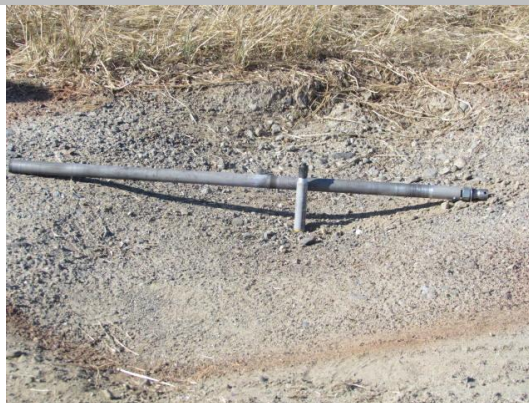
Photo 2 of 3 : SP\_2017\_NA0010\_118\_14\_20170417\_00013.jpg

LM Start	9.57	Rating **	M	Issue No.	14 (cont)	
LM End	9.57	Issue Type +	Ma	Location *	CR	
Category	Earthen Levee			GPS Latitude/Longitude		
				Start		End
Item	Crown Surface / Depressions / Rutting			37.295517 °		37.295517 °
				-120.841452 °		-120.841452 °
DWR ID	DWR_NA0010_01_s_2015_14					
Comment Code						
C2 : Repair depressions or ruts in the crown or slope.						
Inspector Comment						
Depression greater than 3" deep by 18" wide by 18" long on levee crown

Looking west at depression greater than three inches on levee crown.

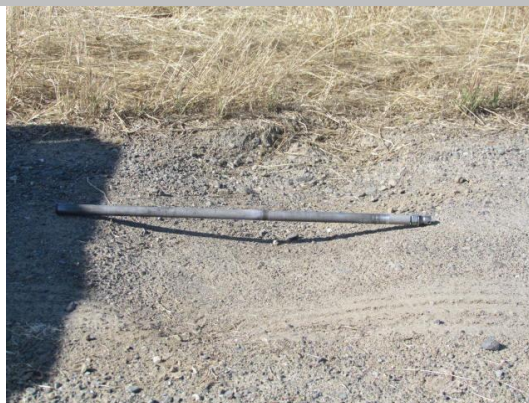
Photo 3 of 3 : SP\_2017\_NA0010\_118\_14\_20170417\_00014.jpg

Looking west at depression on levee crown.

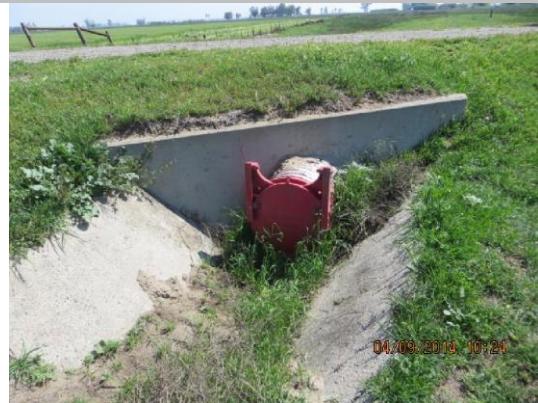
Photo 1 of 1 : UCIP\_SP\_2017\_33683\_60880.jpg

LM Start	9.64	Rating **	A/W	Issue No.	1226
LM End	9.64	Issue Type +	Ma	Location *	CR
Category	Supplemental			GPS Latitude/Longitude	
				Start	End
Item	DWR UCIP LMA Responsibility			37.294845 °	37.294845 °
				-120.840580 °	-120.840580 °
DWR ID					
Comment Code					
Inspector Comment					
FS_ID:33683 DS_ID:19628 EP_NO: N/A Repair Type: No Action Needed Crossing Status: Found UCIP Comments: FIELD_STRUCT_DESC: 24-inch CM stormdrain pipe through the levee, 4.5 feet below the crown. Flap gate on the waterward end. Brass cap No. 80 BM on headwall on the landward side. (USACE-1967). This entry matches the Drainage or Irrigation Structure referenced in O&M manual (HLM 9.67). FS Date: 4/9/2014

Pipe, flapgate, and headwall visible on WS toe.

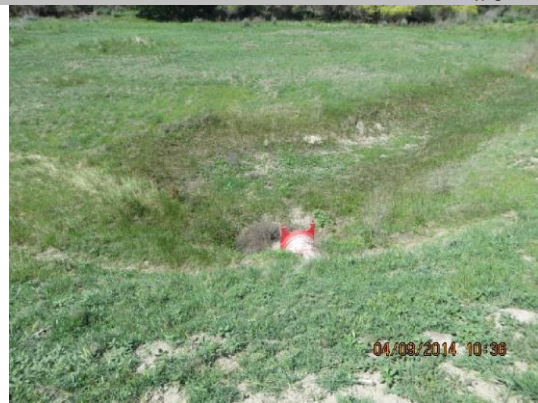
Photo 1 of 3 : UCIP\_SP\_2017\_39253\_60884.jpg

LM Start	10.20	Rating **	M	Issue No.	1227
LM End	10.20	Issue Type +	Ma	Location *	CR
Category	Supplemental			GPS Latitude/Longitude	
				Start	End
Item	DWR UCIP LMA Responsibility		37.287511 °	37.287511 °	
			-120.840251 °	-120.840251 °	
DWR ID					
Comment Code					
Inspector Comment					
FS_ID:39253 DS_ID:19629 EP_NO: N/A Repair Type: Non-Urgent Crossing Status: Found UCIP Comments: Dense vegetation blocks waterward and landward toes Recommend removing vegetation from both toes. Also sediment buildup in pipe visible from landward side. FIELD_STRUCT_DESC: 24-inch CM stormdrain pipe through the levee, 9.0 feet below the crown. Flap gate on the waterward end. Brass cap No. 69 BM on headwall on the landward side. (USACE-1967). This entry matches the Drainage or Irrigation Structure referenced in O&M manual (HLM 10.23). FS Date: 4/9/2014

Pipe, headwall, and flapgate on WS toe.

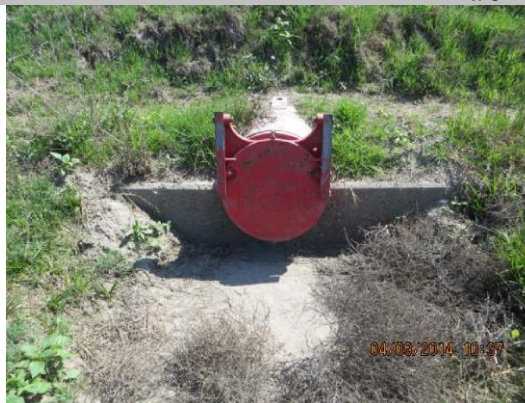
Photo 2 of 3 : UCIP\_SP\_2017\_39253\_60886.jpg

Item	DWR UCIP LMA Responsibility			37.287511 °		37.287511 °
				-120.840251 °		-120.840251 °
DWR ID						
Comment Code						
Inspector Comment						
FS_ID:39253						
DS_ID:19629						
EP_NO: N/A						
Repair Type: Non-Urgent						
Crossing Status: Found						
UCIP Comments: Dense vegetation blocks waterward and landward toes Recommend removing vegetation from both toes. Also sediment buildup in pipe visible from landward side.						
FIELD_STRUCT_DESC: 24-inch CM stormdrain pipe through the levee, 9.0 feet below the crown. Flap gate on the waterward end. Brass cap No. 69 BM on headwall on the landward side. (USACE-1967). This entry matches the Drainage or Irrigation Structure referenced in O&M manual (HLM 10.23).						
FS Date: 4/9/2014

Pipe, headwall, and flapgate at WS toe.

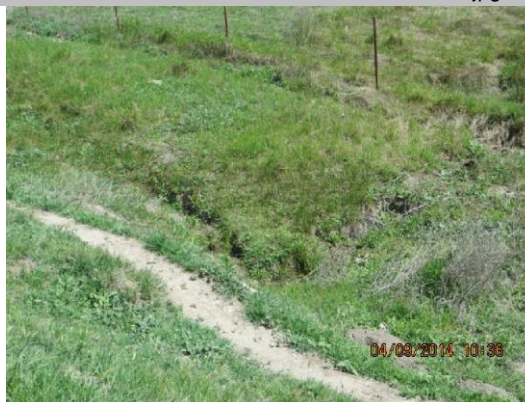
Photo 3 of 3 : UCIP\_SP\_2017\_39253\_60885.jpg

Pipe and headwall at LS toe.

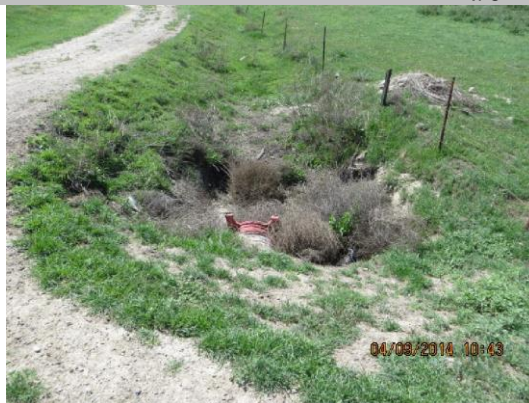
Photo 1 of 3 : UCIP\_SP\_2017\_33687\_60890.jpg

LM Start	10.68	Rating **	A/W	Issue No.	1228
LM End	10.68	Issue Type +	Ma	Location *	CR
Category	Supplemental			GPS Latitude/Longitude	
				Start	End
Item	DWR UCIP LMA Responsibility			37.283740 °	37.283740 °
				-120.833452 °	-120.833452 °
DWR ID					
Comment Code					
Inspector Comment					
FS_ID:33687					
DS_ID:19630					
EP_NO: N/A					
Repair Type: No Action Needed					
Crossing Status: Found					
UCIP Comments:					
FIELD_STRUCT_DESC: 24-inch CM stormdrain pipe through the levee, 7.0 feet below the crown. Flap gate on the waterward end. Brass cap No. 68 BM on headwall on the landward side. (USACE-1967). This entry matches the Drainage or Irrigation Structure referenced in O&M manual (HLM 10.72).					
FS Date: 4/9/2014

Pipe and flapgate on Ws toe.

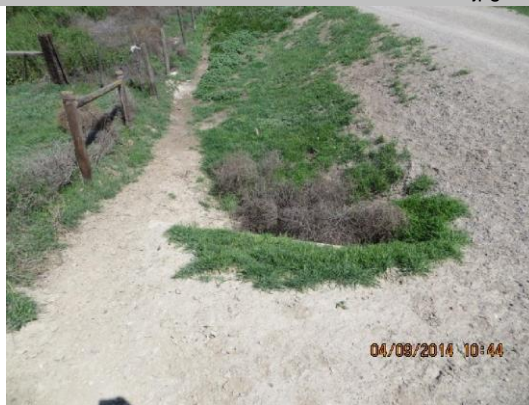
Photo 2 of 3 : UCIP\_SP\_2017\_33687\_60889.jpg

Pipe and headwall on LS toe.

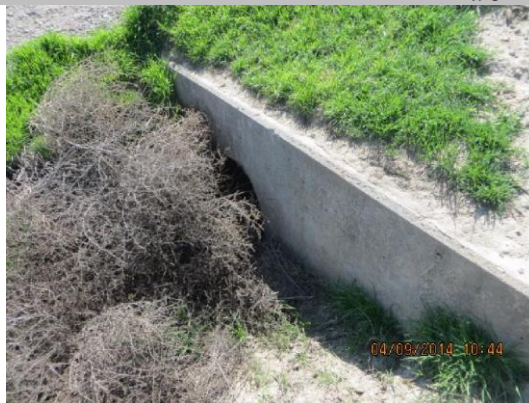
Photo 3 of 3 : UCIP\_SP\_2017\_33687\_60888.jpg

LM Start	10.68	Rating **	A/W	Issue No.	1228 (cont)
LM End	10.68	Issue Type +	Ma	Location *	CR
Category	Supplemental			GPS Latitude/Longitude	
				Start	End
Item	DWR UCIP LMA Responsibility			37.283740 °	37.283740 °
				-120.833452 °	-120.833452 °
DWR ID					
Comment Code					
Inspector Comment					
FS_ID:33687					
DS_ID:19630					
EP_NO: N/A					
Repair Type: No Action Needed					
Crossing Status: Found					
UCIP Comments:					
FIELD_STRUCT_DESC: 24-inch CM stormdrain pipe through the levee, 7.0 feet below the crown. Flap gate on the waterward end. Brass cap No. 68 BM on headwall on the landward side. (USACE-1967). This entry matches the Drainage or Irrigation Structure referenced in O&M manual (HLM 10.72).					
FS Date: 4/9/2014

Pipe and headwall on LS toe.

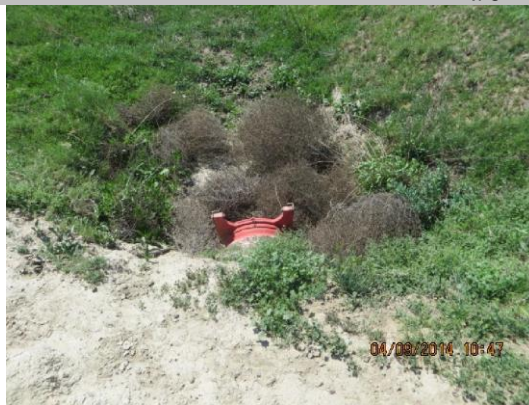
Photo 1 of 3 : UCIP\_SP\_2017\_39254\_60894.jpg

LM Start	10.69	Rating **	A/W	Issue No.	1229
LM End	10.69	Issue Type +	Ma	Location *	CR
Category	Supplemental			GPS Latitude/Longitude	
				Start	End
Item	DWR UCIP LMA Responsibility			37.283710 °	37.283710 °
				-120.833329 °	-120.833329 °
DWR ID					
Comment Code					
Inspector Comment					
FS_ID:39254 DS_ID:19631 EP_NO: N/A Repair Type: No Action Needed Crossing Status: Found UCIP Comments: FIELD_STRUCT_DESC: 24-inch CM stormdrain pipe through the levee, 7.0 feet below the crown. Flap gate on the waterward end. Brass cap No. 67 BM on headwall on the landward side. (USACE-1967). This entry matches the Drainage or Irrigation Structure referenced in O&M manual (HLM 10.72). FS Date: 4/9/2014

Headwall, pipe, and flapgate on WS toe.

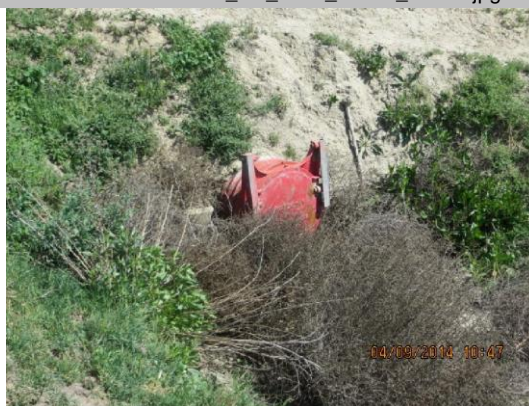
Photo 2 of 3 : UCIP\_SP\_2017\_39254\_60893.jpg

LM Start	10.69	Rating **	A/W	Issue No.	1229 (cont)
LM End	10.69	Issue Type +	Ma	Location *	CR
Category	Supplemental			GPS Latitude/Longitude	
				Start	End
Item	DWR UCIP LMA Responsibility			37.283710 °	37.283710 °
				-120.833329 °	-120.833329 °
DWR ID					
Comment Code					
Inspector Comment					
FS_ID:39254					
DS_ID:19631					
EP_NO: N/A					
Repair Type: No Action Needed					
Crossing Status: Found					
UCIP Comments:					
FIELD_STRUCT_DESC: 24-inch CM stormdrain pipe through the levee, 7.0 feet below the crown. Flap gate on the waterward end. Brass cap No. 67 BM on headwall on the landward side. (USACE-1967). This entry matches the Drainage or Irrigation Structure referenced in O&M manual (HLM 10.72).					
FS Date: 4/9/2014

Headwall, pipe, and flapgate on WS toe.

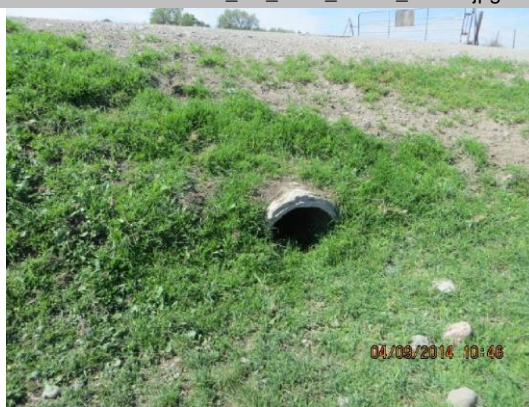
Photo 3 of 3 : UCIP\_SP\_2017\_39254\_60895.jpg

Concrete pipe visible on LS slope.

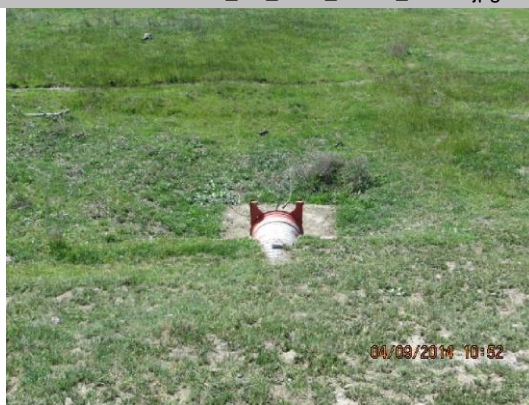
Photo 1 of 3 : UCIP\_SP\_2017\_39255\_60897.jpg

LM Start	10.98	Rating **	M	Issue No.	1230
LM End	10.98	Issue Type +	Ma	Location *	WS
Category	Supplemental			GPS Latitude/Longitude	
				Start	End
Item	DWR UCIP LMA Responsibility			37.282627 °	37.282627 °
				-120.828233 °	-120.828233 °
DWR ID					
Comment Code					
Inspector Comment					
FS_ID:39255 DS_ID:19632 EP_NO: N/A Repair Type: Non-Urgent Crossing Status: Found UCIP Comments: Dense vegetation blocks landward headwall. Recommend removing excess vegetation on landward toe. FIELD_STRUCT_DESC: 24-inch CM stormdrain pipe through the levee, 6.0 feet below the crown. Flap gate on the waterward end. Brass cap No. 66 BM on headwall on the landward side. (USACE-1967). This entry matches the Drainage or Irrigation Structure referenced in O&M manual (HLM 11.00). FS Date: 4/9/2014

Pipe, headwall, and flapgate on WS toe.

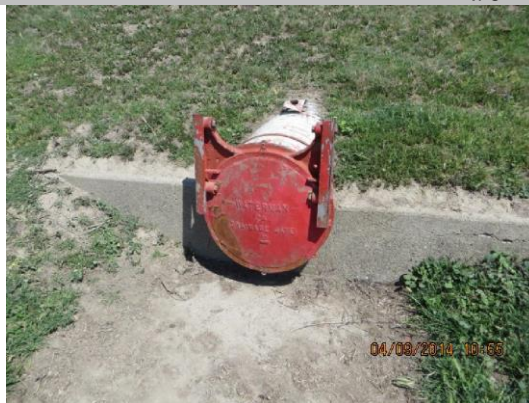
Photo 2 of 3 : UCIP\_SP\_2017\_39255\_60899.jpg

LM Start	10.98	Rating **	M	Issue No.	1230 (cont)
LM End	10.98	Issue Type +	Ma	Location *	WS
Category	Supplemental			GPS Latitude/Longitude	
				Start	End
Item	DWR UCIP LMA Responsibility			37.282627 °	37.282627 °
				-120.828233 °	-120.828233 °
DWR ID					
Comment Code					
Inspector Comment					
FS_ID:39255 DS_ID:19632 EP_NO: N/A Repair Type: Non-Urgent Crossing Status: Found UCIP Comments: Dense vegetation blocks landward headwall. Recommend removing excess vegetation on landward toe. FIELD_STRUCT_DESC: 24-inch CM stormdrain pipe through the levee, 6.0 feet below the crown. Flap gate on the waterward end. Brass cap No. 66 BM on headwall on the landward side. (USACE-1967). This entry matches the Drainage or Irrigation Structure referenced in O&M manual (HLM 11.00). FS Date: 4/9/2014

Pipe, headwall, and flapgate on WS toe.

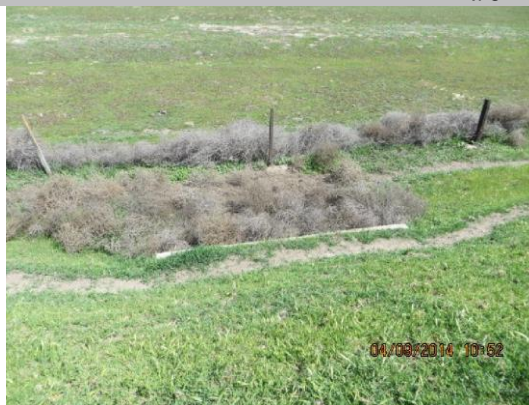
Photo 3 of 3 : UCIP\_SP\_2017\_39255\_60898.jpg

Pipe and headwall on LS toe.

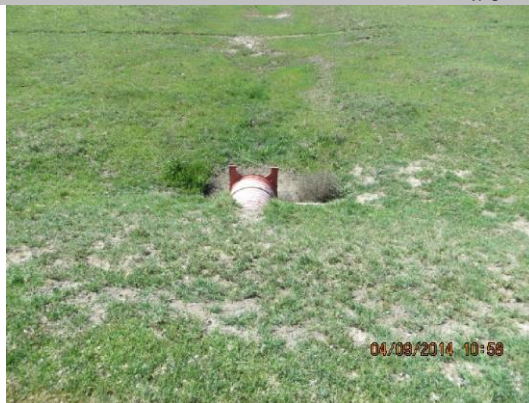
Photo 1 of 3 : UCIP\_SP\_2017\_33690\_60903.jpg

LM Start	11.14	Rating **	A/W	Issue No.	1231
LM End	11.14	Issue Type +	Ma	Location *	WS
Category	Supplemental			GPS Latitude/Longitude	
				Start	End
Item	DWR UCIP LMA Responsibility			37.281813 °	37.281813 °
				-120.825409 °	-120.825409 °
DWR ID					
Comment Code					
Inspector Comment					
FS_ID:33690					
DS_ID:19633					
EP_NO: N/A					
Repair Type: No Action Needed					
Crossing Status: Found					
UCIP Comments:					
FIELD_STRUCT_DESC: 24-inch CM stormdrain pipe through the levee, 5.0 feet below the crown. Flap gate on the waterward end. Brass cap No. 65 BM on headwall on the landward side. (USACE-1967). This entry matches the Drainage or Irrigation Structure referenced in O&M manual (HLM 11.18).					
FS Date: 4/9/2014

Pipe, headwall, and flapgate on WS toe.

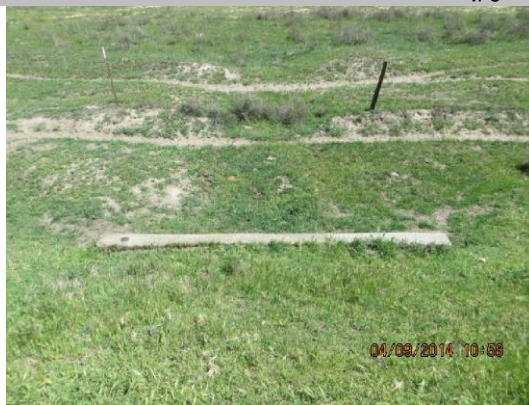
Photo 2 of 3 : UCIP\_SP\_2017\_33690\_60902.jpg

Pipe and headwall at LS toe.

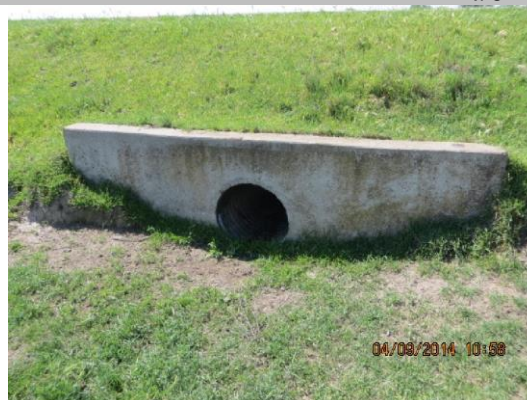
Photo 3 of 3 : UCIP\_SP\_2017\_33690\_60901.jpg

LM Start	11.14	Rating **	A/W	Issue No.	1231 (cont)
LM End	11.14	Issue Type +	Ma	Location *	WS
Category	Supplemental			GPS Latitude/Longitude	
				Start	End
Item	DWR UCIP LMA Responsibility			37.281813 °	37.281813 °
				-120.825409 °	-120.825409 °
DWR ID					
Comment Code					
Inspector Comment					
FS_ID:33690					
DS_ID:19633					
EP_NO: N/A					
Repair Type: No Action Needed					
Crossing Status: Found					
UCIP Comments:					
FIELD_STRUCT_DESC: 24-inch CM stormdrain pipe through the levee, 5.0 feet below the crown. Flap gate on the waterward end. Brass cap No. 65 BM on headwall on the landward side. (USACE-1967). This entry matches the Drainage or Irrigation Structure referenced in O&M manual (HLM 11.18).					
FS Date: 4/9/2014

Pipe and headwall at LS toe.

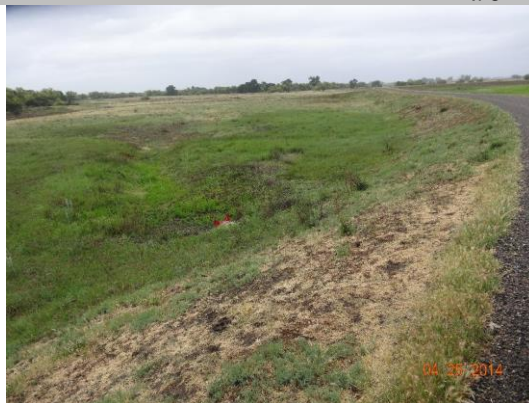
Photo 1 of 3 : UCIP\_SP\_2017\_36103\_65362.jpg

LM Start	11.49	Rating **	M	Issue No.	1233
LM End	11.49	Issue Type +	Ma	Location *	WS
Category	Supplemental			GPS Latitude/Longitude	
				Start	End
Item	DWR UCIP LMA Responsibility			37.273787 °	37.273787 °
				-120.825519 °	-120.825519 °
DWR ID					
Comment Code					
Inspector Comment					
FS_ID:36103 DS_ID:19634 EP_NO: N/A Repair Type: Non-Urgent Crossing Status: Found UCIP Comments: Need to contact owner--landward side has been buried. It appears that soil was removed from levee toe, immediately upstream, and used to pile soil at landward side at crossing. FIELD_STRUCT_DESC: 24-inch CM pipe through the levee, 10.0 feet below the crown. Flap gate on the waterward end. Brass cap No. 62 BM on headwall on the landward side. (USACE-1967). This entry matches the Drainage or Irrigation Structure referenced in O&M manual (HLM 11.48). FS Date: 4/25/2014

View of waterward side.

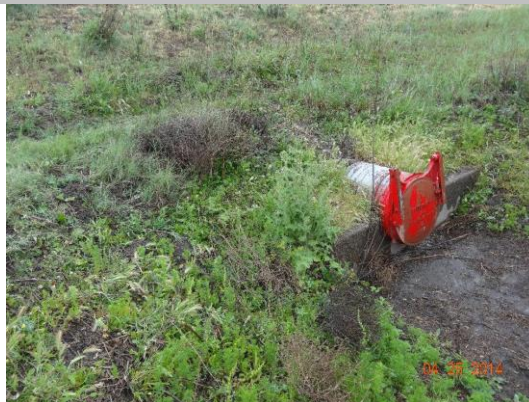
Photo 2 of 3 : UCIP\_SP\_2017\_36103\_65364.jpg

View of concrete headwall and flap gate visible on waterward side.

LM Start	11.49	Rating **	M	Issue No.	1233 (cont)	
LM End	11.49	Issue Type +	Ma	Location *	WS	
Category	Supplemental			GPS Latitude/Longitude		
				Start		End
Item	DWR UCIP LMA Responsibility			37.273787 °		37.273787 °
				-120.825519 °		-120.825519 °
DWR ID						
Comment Code						
Inspector Comment						
FS_ID:36103 DS_ID:19634 EP_NO: N/A Repair Type: Non-Urgent Crossing Status: Found UCIP Comments: Need to contact owner--landward side has been buried. It appears that soil was removed from levee toe, immediately upstream, and used to pile soil at landward side at crossing. FIELD_STRUCT_DESC: 24-inch CM pipe through the levee, 10.0 feet below the crown. Flap gate on the waterward end. Brass cap No. 62 BM on headwall on the landward side. (USACE-1967). This entry matches the Drainage or Irrigation Structure referenced in O&M manual (HLM 11.48). FS Date: 4/25/2014

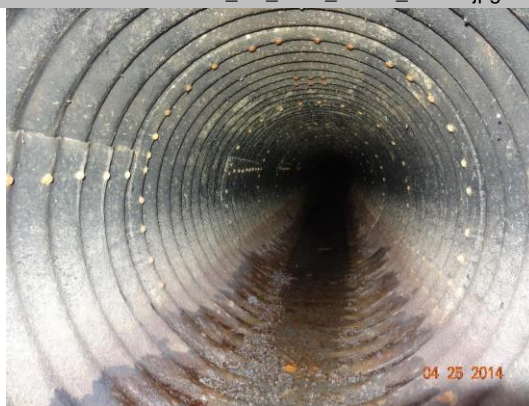
Photo 3 of 3 : UCIP\_SP\_2017\_36103\_65363.jpg

Inside view of pipe from waterward side.

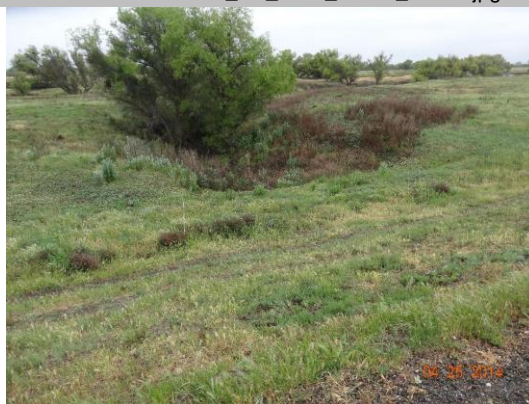
Photo 1 of 3 : UCIP\_SP\_2017\_36105\_65372.jpg

Comment Code					
Inspector Comment					
FS_ID:36105 DS_ID:19635 EP_NO: N/A Repair Type: Non-Urgent Crossing Status: Found UCIP Comments: Crossing is non-functional --landward side is buried. Debris found on landward side (channel). Dense vegetation found on waterward slope. Recommend contacting owner to determine status of crossing. If crossing is no longer used need to coordinate with CVFPB for proper abandonment. FIELD_STRUCT_DESC: 24-inch CM pipe through the levee, 17.0 feet below the crown. Flap gate on the waterward end. Brass cap No. 61 BM on headwall on the landward side. (USACE-1967). This entry matches the Drainage or Irrigation Structure referenced in O&M manual (HLM 11.76). FS Date: 4/25/2014

View of waterward side.

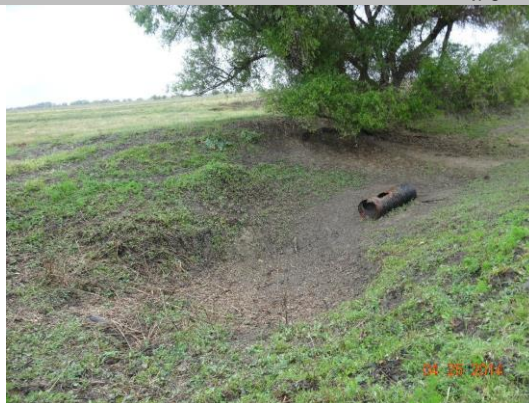
Photo 2 of 3 : UCIP\_SP\_2017\_36105\_65371.jpg

Item	DWR UCIP LMA Responsibility			37.269701 °	37.269701 °	
				-120.826450 °	-120.826450 °	
DWR ID						
Comment Code						
Inspector Comment						
FS_ID:36105 DS_ID:19635 EP_NO: N/A Repair Type: Non-Urgent Crossing Status: Found UCIP Comments: Crossing is non-functional --landward side is buried. Debris found on landward side (channel). Dense vegetation found on waterward slope. Recommend contacting owner to determine status of crossing. If crossing is no longer used need to coordinate with CVFPB for proper abandonment. FIELD_STRUCT_DESC: 24-inch CM pipe through the levee, 17.0 feet below the crown. Flap gate on the waterward end. Brass cap No. 61 BM on headwall on the landward side. (USACE-1967). This entry matches the Drainage or Irrigation Structure referenced in O&M manual (HLM 11.76). FS Date: 4/25/2014

Landward side of crossing buried--damage pipe section visible on landward side.

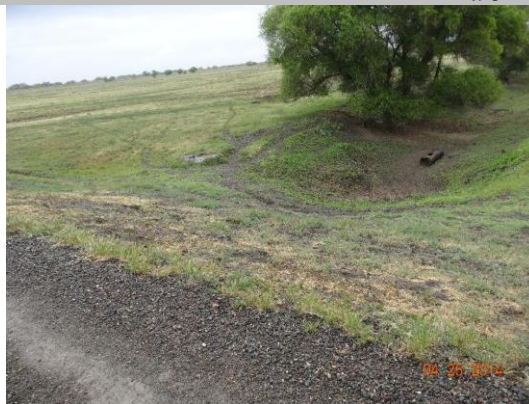
Photo 3 of 3 : UCIP\_SP\_2017\_36105\_65373.jpg

View of landward side.

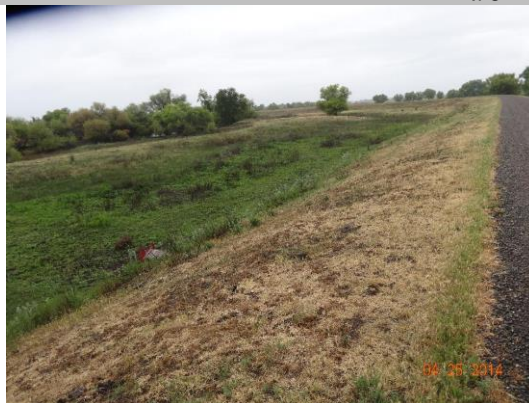
Photo 1 of 3 : UCIP\_SP\_2017\_36106\_65378.jpg

Comment Code					
Inspector Comment					
FS_ID:36106 DS_ID:19636 EP_NO: N/A Repair Type: Non-Urgent Crossing Status: Found UCIP Comments: Crossing is non-functional --landward side is buried. Dense vegetation found on waterward slope. Recommend contacting owner to determine status of crossing. If crossing is no longer used need to coordinate with CVFPB for proper abandonment. FIELD_STRUCT_DESC: 24-inch CM pipe through the levee, 12.4 feet below the crown. Flap gate on the waterward end. Brass cap No. 60 BM on headwall on the landward side. (USACE-1967). This entry matches the Drainage or Irrigation Structure referenced in O&M manual (HLM 12.11). FS Date: 4/25/2014

View of waterward side--flap gate visible on waterward toe.

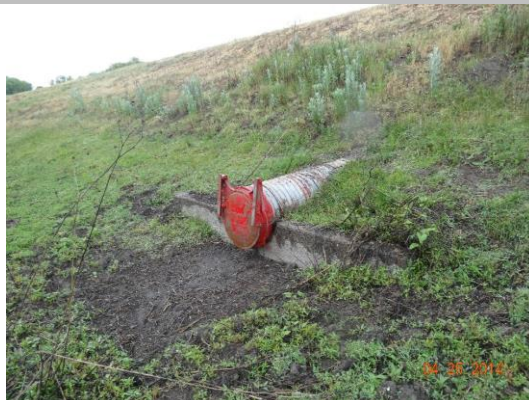
Photo 2 of 3 : UCIP\_SP\_2017\_36106\_65379.jpg

Flap gate and concrete headwall visible on waterward side.

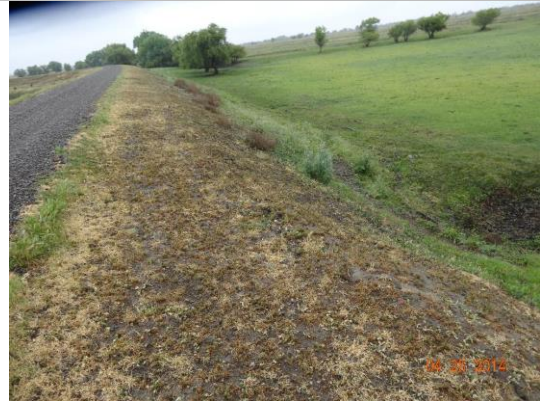
Photo 3 of 3 : UCIP\_SP\_2017\_36106\_65377.jpg

Item	DWR UCIP LMA Responsibility			37.265336 °		37.265336 °
				-120.826591 °		-120.826591 °
DWR ID						
Comment Code						
Inspector Comment						
FS_ID:36106						
DS_ID:19636						
EP_NO: N/A						
Repair Type: Non-Urgent						
Crossing Status: Found						
UCIP Comments: Crossing is non-functional --landward side is buried.						
Dense vegetation found on waterward slope. Recommend contacting						
owner to determine status of crossing. If crossing is no longer used						
need to coordinate with CVFPB for proper abandonment.						
FIELD_STRUCT_DESC: 24-inch CM pipe through the levee, 12.4 feet						
below the crown. Flap gate on the waterward end. Brass cap No. 60 BM						
on headwall on the landward side. (USACE-1967). This entry matches						
the Drainage or Irrigation Structure referenced in O&M manual (HLM

View of landward side.

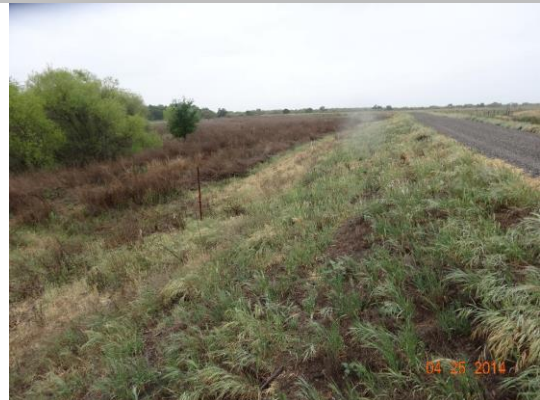
Photo 1 of 3 : UCIP\_SP\_2017\_36146\_65412.jpg

Comment Code					
Inspector Comment					
FS_ID:36146 DS_ID:19637 EP_NO: N/A Repair Type: Non-Urgent Crossing Status: Found UCIP Comments: Concrete headwall on landward side blocked by debris. Dense vegetation limits the inspector's visibility to identify signs of pipe failure (leaks) along the landward slope. Recommend removing vegetation along pipe alignment to conduct proper inspection of crossing. FIELD_STRUCT_DESC: 24-inch CM pipe through the levee, 9.5 feet below the crown. Flap gate on the waterward end. Brass cap No. 60 BM on headwall on the landward side. (USACE-1967). This entry matches the Drainage or Irrigation Structure referenced in O&M manual (HLM 12.94). FS Date: 4/25/2014

View of waterward side.

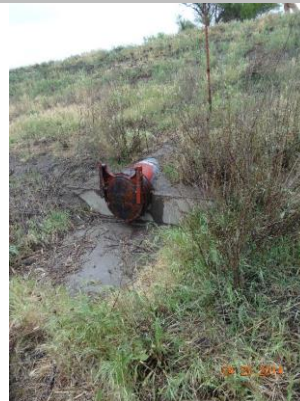
Photo 2 of 3 : UCIP\_SP\_2017\_36146\_65411.jpg

Item	DWR UCIP LMA Responsibility			37.256873 °	37.256873 °	
				-120.821277 °	-120.821277 °	
DWR ID						
Comment Code						
Inspector Comment						
FS_ID:36146 DS_ID:19637 EP_NO: N/A Repair Type: Non-Urgent Crossing Status: Found UCIP Comments: Concrete headwall on landward side blocked by debris. Dense vegetation limits the inspector's visibility to identify signs of pipe failure (leaks) along the landward slope. Recommend removing vegetation along pipe alignment to conduct proper inspection of crossing. FIELD_STRUCT_DESC: 24-inch CM pipe through the levee, 9.5 feet below the crown. Flap gate on the waterward end. Brass cap No. 60 BM on headwall on the landward side. (USACE-1967). This entry matches the Drainage or Irrigation Structure referenced in O&M manual (HLM 12.94). FS Date: 4/25/2014

Flap gate and concrete headwall visible on waterward side.

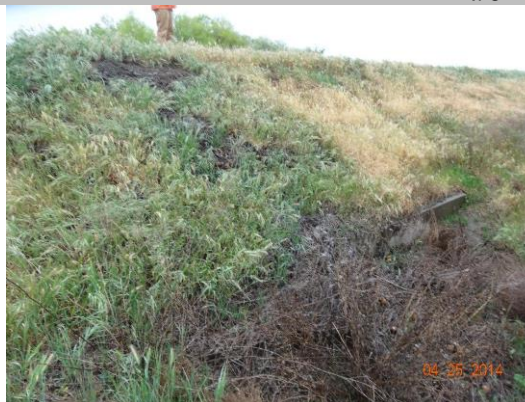
Photo 3 of 3 : UCIP\_SP\_2017\_36146\_65410.jpg

View of landward side--concrete headwall visible covered by dense vegetation.

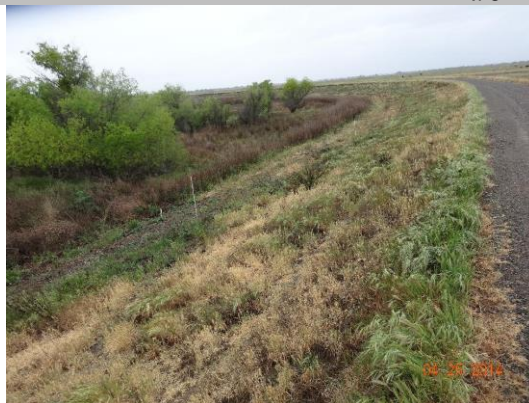
Photo 1 of 3 : UCIP\_SP\_2017\_36109\_65389.jpg

Comment Code					
Inspector Comment					
FS_ID:36109 DS_ID:19638 EP_NO: N/A Repair Type: Non-Urgent Crossing Status: Found UCIP Comments: Dense vegetation limits the inspector's visibility to identify signs of pipe failure (leaks) along the landward slope. Concrete headwall blocked by debris located on landward toe. Recommend clearing debris from landward slope and toe. FIELD_STRUCT_DESC: 24-inch CM pipe through the levee, 14.2 feet below the crown. Flap gate on the waterward end. Brass cap No. 60 BM on headwall on the landward side. (USACE-1967). This entry matches the Drainage or Irrigation Structure referenced in O&M manual (HLM 13.48). FS Date: 4/25/2014

View of waterward side.

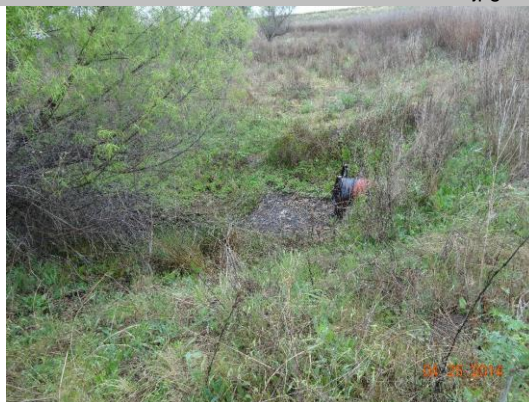
Photo 2 of 3 : UCIP\_SP\_2017\_36109\_65387.jpg

View of flap gate and pipe through levee on waterward side.

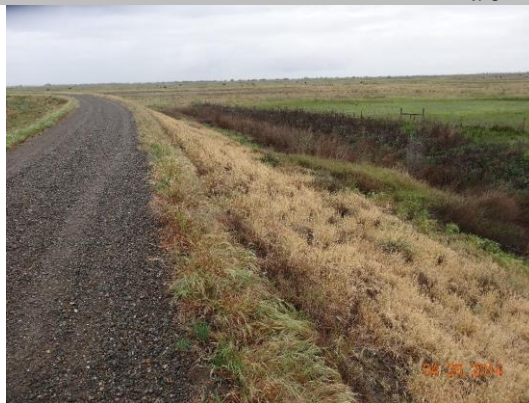
Photo 3 of 3 : UCIP\_SP\_2017\_36109\_65388.jpg

Item	DWR UCIP LMA Responsibility			37.251590 °		37.251590 °
				-120.814354 °		-120.814354 °
DWR ID						
Comment Code						
Inspector Comment						
FS_ID:36109 DS_ID:19638 EP_NO: N/A Repair Type: Non-Urgent Crossing Status: Found UCIP Comments: Dense vegetation limits the inspector's visibility to identify signs of pipe failure (leaks) along the landward slope. Concrete headwall blocked by debris located on landward toe. Recommend clearing debris from landward slope and toe. FIELD_STRUCT_DESC: 24-inch CM pipe through the levee, 14.2 feet below the crown. Flap gate on the waterward end. Brass cap No. 60 BM on headwall on the landward side. (USACE-1967). This entry matches the Drainage or Irrigation Structure referenced in O&M manual (HLM 13.48). FS Date: 4/25/2014

View of landward side.

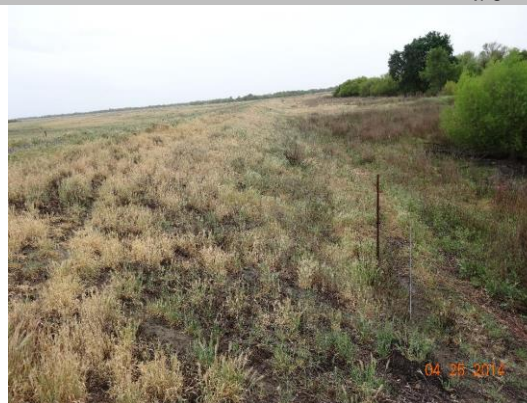
Photo 1 of 3 : UCIP\_SP\_2017\_39256\_65418.jpg

FS\_ID:39256  
DS\_ID:19639  
EP\_NO: N/A  
Repair Type: Non-Urgent  
Crossing Status: Found  
UCIP Comments: No access to waterward toe due to fence. Unable to find the concrete headwall and flap gate on waterward side past fence. Also dense vegetation limits the inspector's visibility to identify signs of pipe failure (leaks) along the waterward slope. Recommend removing vegetation along pipe alignment to conduct proper inspection of structure. Also need access past fence on waterward side.  
FIELD\_STRUCT\_DESC: 24-inch CM pipe through the levee, 14.5 feet below the crown. Flap gate on the waterward end. Brass cap No. 60 BM on headwall on the landward side. (USACE-1967). This entry matches the Drainage or Irrigation Structure referenced in O&M manual (HLM 13.58).  
FS Date: 4/25/2014

View of waterward side.

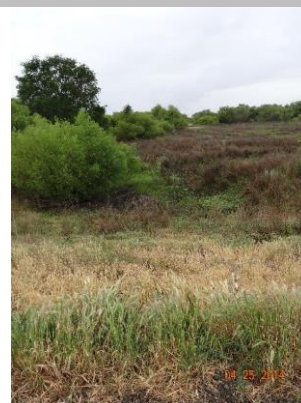
Photo 2 of 3 : UCIP\_SP\_2017\_39256\_65417.jpg

Dense vegetation on waterward side.

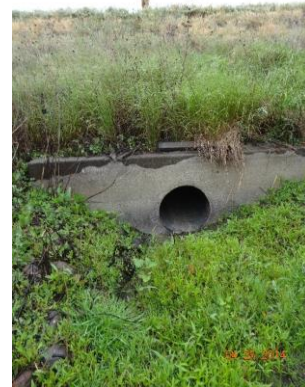
Photo 3 of 3 : UCIP\_SP\_2017\_39256\_65416.jpg

Item	DWR UCIP LMA Responsibility			37.250138 °	37.250138 °	
				-120.814720 °	-120.814720 °	
DWR ID						
Comment Code						
Inspector Comment						
FS_ID:39256 DS_ID:19639 EP_NO: N/A Repair Type: Non-Urgent Crossing Status: Found UCIP Comments: No access to waterward toe due to fence. Unable to find the concrete headwall and flap gate on waterward side past fence. Also dense vegetation limits the inspector's visibility to identify signs of pipe failure (leaks) along the waterward slope. Recommend removing vegetation along pipe alignment to conduct proper inspection of structure. Also need access past fence on waterward side. FIELD_STRUCT_DESC: 24-inch CM pipe through the levee, 14.5 feet below the crown. Flap gate on the waterward end. Brass cap No. 60 BM on headwall on the landward side. (USACE-1967). This entry matches the Drainage or Irrigation Structure referenced in O&M manual (HLM 13.58). FS Date: 4/25/2014

Concrete headwall visible from landward side.

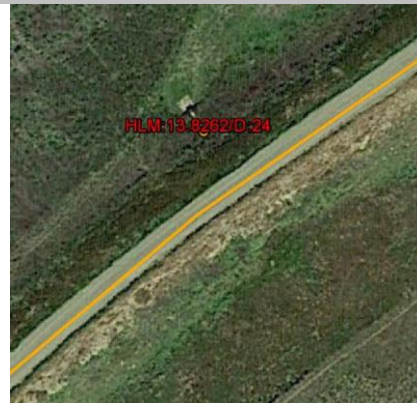
Photo 1 of 1 : UCIP\_SP\_2017\_36544\_66286.jpg

LM Start	13.82	Rating **	M	Issue No.	1239
LM End	13.82	Issue Type +	En	Location *	WS
Category	Supplemental			GPS Latitude/Longitude	
				Start	End
Item	DWR UCIP Field Study			37.247568 °	37.247568 °
				-120.817074 °	-120.817074 °
DWR ID					
Comment Code					
Inspector Comment					
FS_ID:36544					
DS_ID:19640					
EP_NO: N/A					
Repair Type: Non-Urgent					
Crossing Status: Indicator Found					
UCIP Comments: No photos available--missed crossing. Aerial photograph indicates crossing is present. Need to confirm if crossing is still present on waterward side.					
FIELD_STRUCT_DESC: 24-inch CM pipe through the levee, 11.0 feet below the crown. Flap gate on the waterward end. Brass cap No. 60 BM on headwall on the landward side. (USACE-1967). This entry matches the Drainage or Irrigation Structure referenced in O&M manual (HLM 13.81).					
FS Date: 4/25/2014

Indicators of crossing visible from aerial photograph.

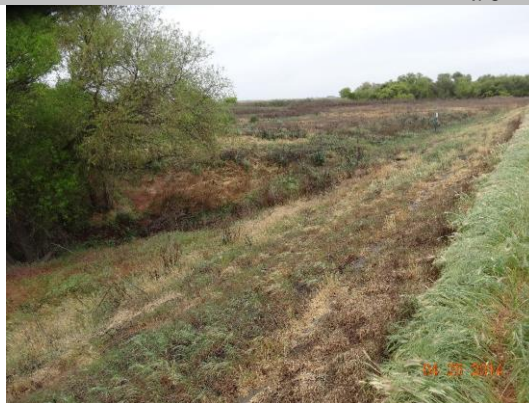
Photo 1 of 3 : UCIP\_SP\_2017\_36166\_65449.jpg

LM Start	14.22	Rating **	M	Issue No.	1240
LM End	14.22	Issue Type +	Ma	Location *	WS
Category	Supplemental			GPS Latitude/Longitude	
				Start	End
Item	DWR UCIP LMA Responsibility			37.242225 °	37.242225 °
				-120.817665 °	-120.817665 °
DWR ID					
Comment Code					
Inspector Comment					
FS_ID:36166 DS_ID:19641 EP_NO: N/A Repair Type: Non-Urgent Crossing Status: Found UCIP Comments: Dense vegetation limits the inspector's visibility to identify signs of pipe failure (leaks) along the slopes. Recommend removing vegetation along pipe alignment to conduct proper inspection of structure. FIELD_STRUCT_DESC: 24-inch CM pipe through the levee, 13.0 feet below the crown. Flap gate on the waterward end. Brass cap No. 60 BM on headwall on the landward side. (USACE-1967). This entry matches the Drainage or Irrigation Structure referenced in O&M manual (HLM 14.21). FS Date: 4/25/2014

View of waterward side.

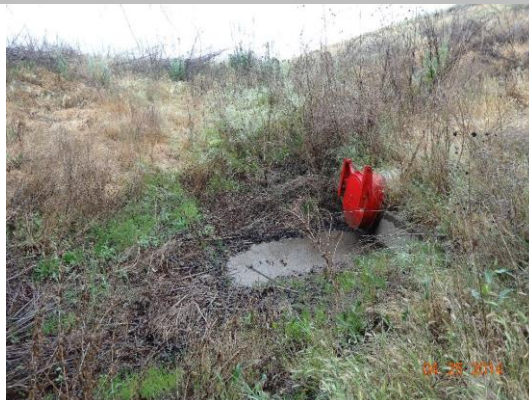
Photo 2 of 3 : UCIP\_SP\_2017\_36166\_65452.jpg

View of concrete headwall, concrete apron, and flap gate on waterward side.

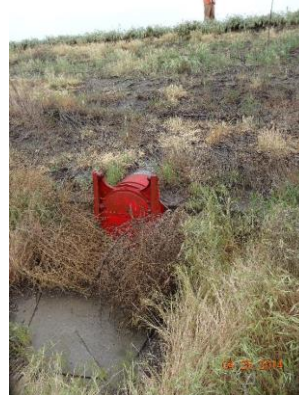
Photo 2 of 3 : UCIP\_SP\_2017\_36167\_65454.jpg

Comment Code					
Inspector Comment					
FS_ID:36167 DS_ID:19642 EP_NO: N/A Repair Type: Non-Urgent Crossing Status: Found UCIP Comments: Dense vegetation limits the inspector's visibility to identify signs of pipe failure (leaks) along the landward slope and toe. Recommend removing vegetation along pipe alignment to conduct proper inspection of structure. FIELD_STRUCT_DESC: 24-inch CM pipe through the levee, 9.7 feet below the crown. Flap gate on the waterward end. Brass cap No. 60 BM on headwall on the landward side. (USACE-1967). This entry matches the Drainage or Irrigation Structure referenced in O&M manual (HLM 14.65). FS Date: 4/25/2014

Flap gate, concrete headwall, and concrete apron located on waterward toe.

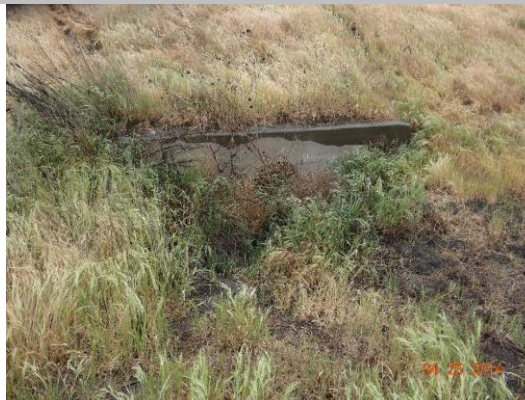
Photo 3 of 3 : UCIP\_SP\_2017\_36167\_65453.jpg

Concrete headwall located on landward toe.

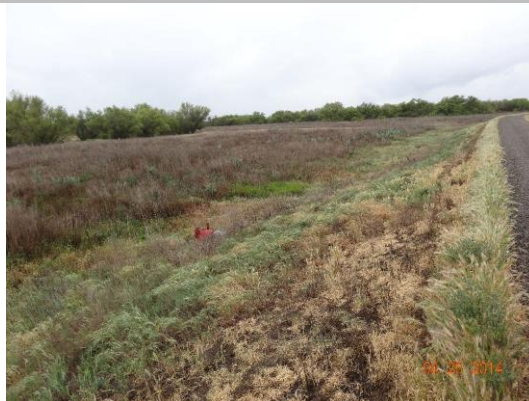
Photo 1 of 3 : UCIP\_SP\_2017\_36168\_65459.jpg

View of waterward side.

Item	DWR UCIP LMA Responsibility			37.231428 °		37.231428 °
				-120.805543 °		-120.805543 °
DWR ID						
Comment Code						
Inspector Comment						
FS_ID:36168						
DS_ID:19643						
EP_NO: N/A						
Repair Type: Non-Urgent						
Crossing Status: Found						
UCIP Comments: Dense vegetation limits the inspector's visibility to identify signs of pipe failure (leaks) along the landward slope.						
Recommend removing vegetation along pipe alignment to conduct proper inspection of structure.						
FIELD_STRUCT_DESC: 24-inch CM pipe through the levee, 9.2 feet below the crown. Flap gate on the waterward end. Brass cap No. 60 BM on headwall on the landward side. (USACE-1967). This entry matches the Drainage or Irrigation Structure referenced in O&M manual (HLM 15.29).						
FS Date: 4/25/2014

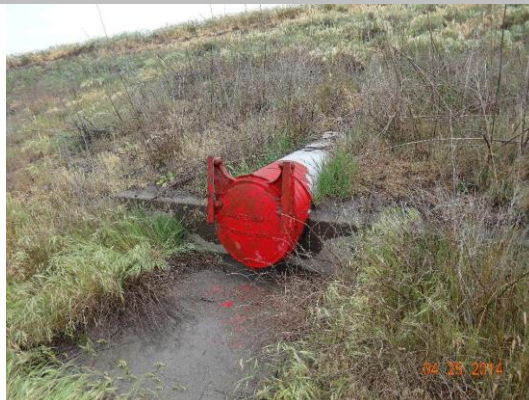
Photo 2 of 3 : UCIP\_SP\_2017\_36168\_65457.jpg

Concrete headwall, flap gate, and concrete apron located on waterward side.

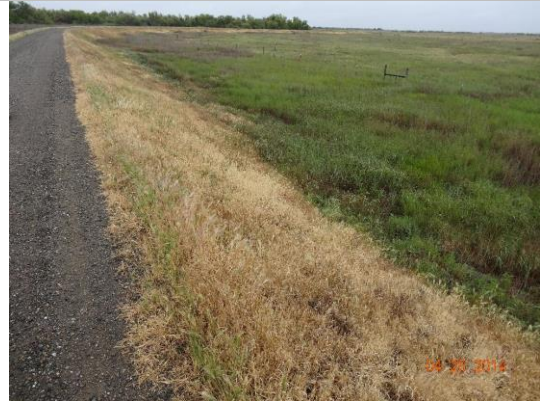
Photo 3 of 3 : UCIP\_SP\_2017\_36168\_65458.jpg

View of landward side.

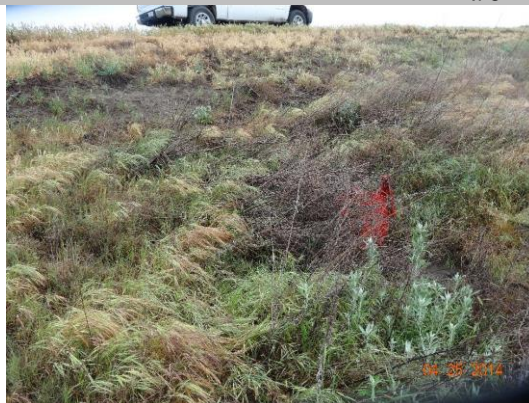
Photo 2 of 3 : UCIP\_SP\_2017\_36169\_65463.jpg

Item	DWR UCIP LMA Responsibility			37.228155 °		37.228155 °
				-120.802645 °		-120.802645 °
DWR ID						
Comment Code						
Inspector Comment						
FS_ID:36169 DS_ID:19644 EP_NO: N/A Repair Type: Non-Urgent Crossing Status: Found UCIP Comments: Dense vegetation limits the inspector's visibility to identify signs of pipe failure (leaks) along the waterward and landward slopes. Recommend removing vegetation along pipe alignment to conduct proper inspection of structure. FIELD_STRUCT_DESC: 24-inch CM pipe through the levee, 8.5 feet below the crown. Flap gate on the waterward end. Brass cap No. 60 BM on headwall on the landward side. (USACE-1967). This entry matches the Drainage or Irrigation Structure referenced in O&M manual (HLM 15.57). FS Date: 4/25/2014

View of waterward slope covered by dense vegetation.

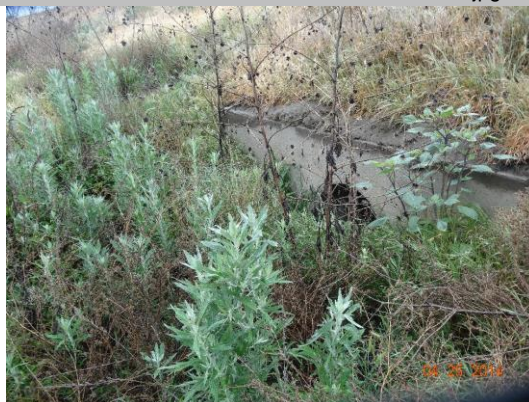
Photo 3 of 3 : UCIP\_SP\_2017\_36169\_65462.jpg

Concrete headwall visible on landward toe--dense vegetation blocking inlet.

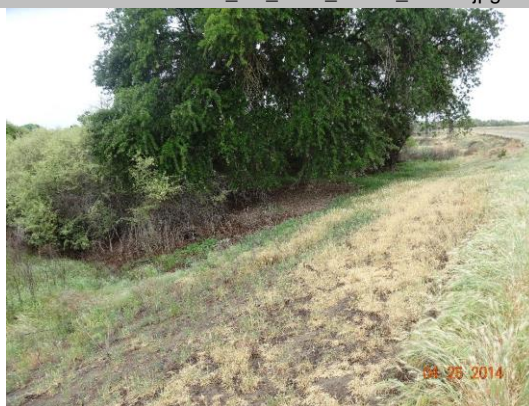
Photo 1 of 3 : UCIP\_SP\_2017\_36171\_65471.jpg

Comment Code					
Inspector Comment					
FS_ID:36171 DS_ID:19645 EP_NO: N/A Repair Type: Non-Urgent Crossing Status: Found UCIP Comments: Dense vegetation limits the inspector's visibility to identify signs of pipe failure (leaks) along the waterward and landward slope. Recommend removing vegetation along pipe alignment to conduct proper inspection of structure. FIELD_STRUCT_DESC: 24-inch CM pipe through the levee, 11.0 feet below the crown. Flap gate on the waterward end. Brass cap No. 60 BM on headwall on the landward side. (USACE-1967). This entry matches the Drainage or Irrigation Structure referenced in O&M manual (HLM 15.81). FS Date: 4/25/2014

View of waterward side.

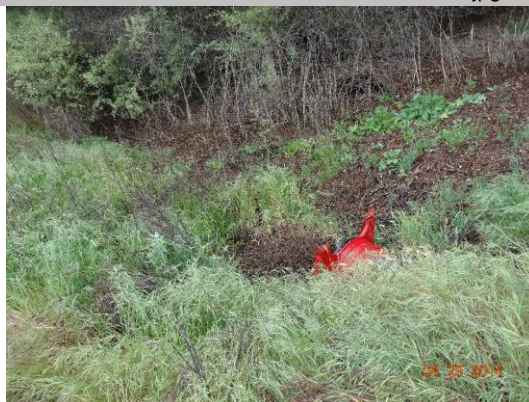
Photo 2 of 3 : UCIP\_SP\_2017\_36171\_65470.jpg

Flap gate visible on waterward side.

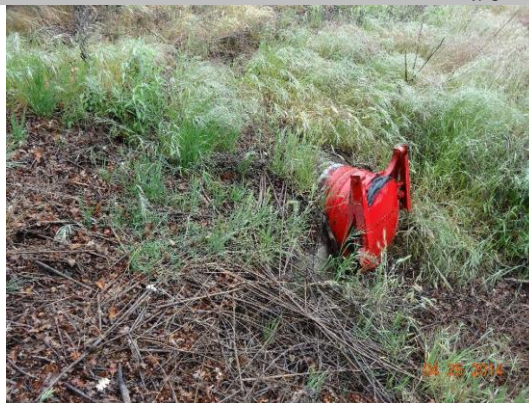
Photo 3 of 3 : UCIP\_SP\_2017\_36171\_65469.jpg

Side view of pipe and flap gate on waterward side.

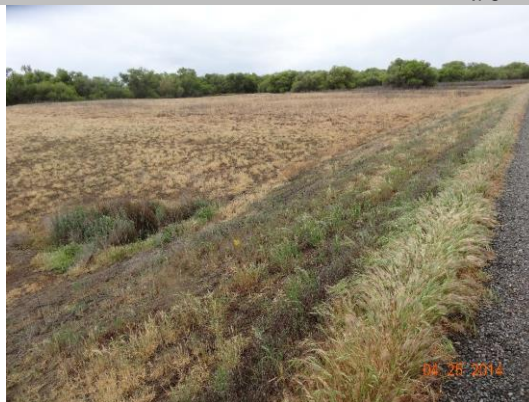
Photo 1 of 3 : UCIP\_SP\_2017\_36172\_65476.jpg

Comment Code					
Inspector Comment					
FS_ID:36172 DS_ID:19646 EP_NO: N/A Repair Type: Non-Urgent Crossing Status: Found UCIP Comments: Dense vegetation limits the inspector's visibility to identify signs of pipe failure (leaks) along the waterward and landward slopes. Recommend removing vegetation along pipe alignment to conduct proper inspection of structure and appurtenances. FIELD_STRUCT_DESC: 24-inch CM pipe through the levee, 11.3 feet below the crown. Flap gate on the waterward end. Brass cap No. 50 BM on headwall on the landward side. (USACE-1967). This entry matches the Drainage or Irrigation Structure referenced in O&M manual (HLM 16.09). FS Date: 4/25/2014

View of waterward side.

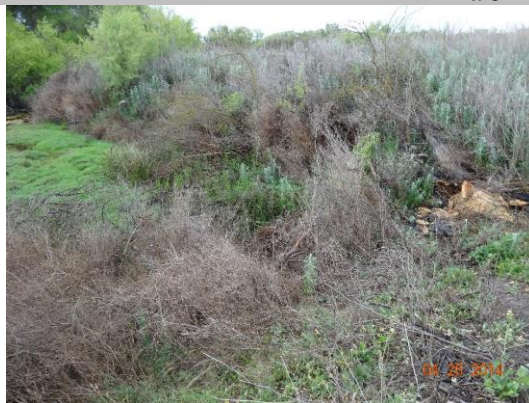
Photo 1 of 3 : UCIP\_SP\_2017\_39257\_65480.jpg

Comment Code					
Inspector Comment					
FS_ID:39257 DS_ID:19647 EP_NO: N/A Repair Type: Non-Urgent Crossing Status: Found UCIP Comments: Dense vegetation limits the inspector's visibility to identify signs of pipe failure (leaks) along the waterward and landward slopes. Recommend removing vegetation along pipe alignment to conduct proper inspection of structure. Unable to find pipe on landward side. FIELD_STRUCT_DESC: 24-inch CM pipe through the levee, 14.7 feet below the crown. Flap gate on the waterward end. Brass cap No. 50 BM on headwall on the landward side. (USACE-1967). This entry matches the Drainage or Irrigation Structure referenced in O&M manual (HLM 16.15). FS Date: 4/25/2014

View of waterward side.

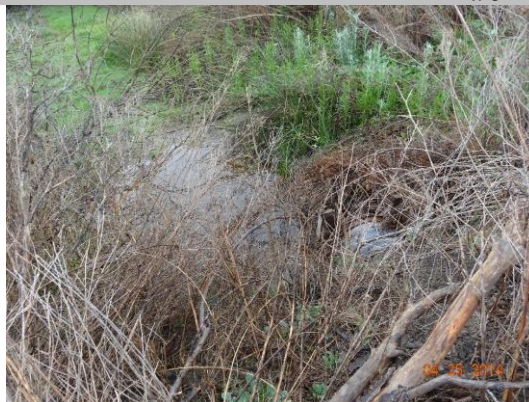
Photo 2 of 3 : UCIP\_SP\_2017\_39257\_65479.jpg

Crossing visible on waterward side under dense vegetation.

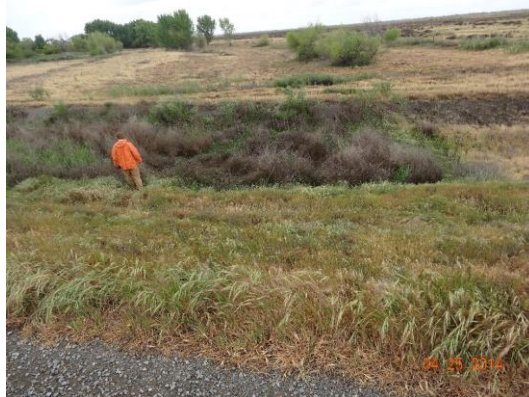
Photo 3 of 3 : UCIP\_SP\_2017\_39257\_65478.jpg

View of landward side.

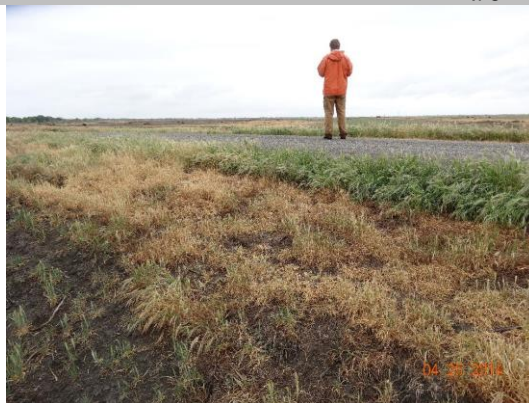
Photo 1 of 3 : UCIP\_SP\_2017\_39258\_66288.jpg

Comment Code					
Inspector Comment					
FS_ID:39258 DS_ID:19648 EP_NO: N/A Repair Type: Non-Urgent Crossing Status: Found UCIP Comments: Dense vegetation limits the inspector's visibility to identify signs of pipe failure (leaks) along the waterward and landward slopes. Recommend removing vegetation along pipe alignment to conduct proper inspection of structure. Unable to find pipe on landward side. FIELD_STRUCT_DESC: 24-inch CM pipe through the levee, 11.4 feet below the crown. Flap gate on the waterward end. Brass cap No. 50 BM on headwall on the landward side. (USACE-1967). This entry matches the Drainage or Irrigation Structure referenced in O&M manual (HLM 16.72). FS Date: 4/25/2014

View of levee crown at crossing.

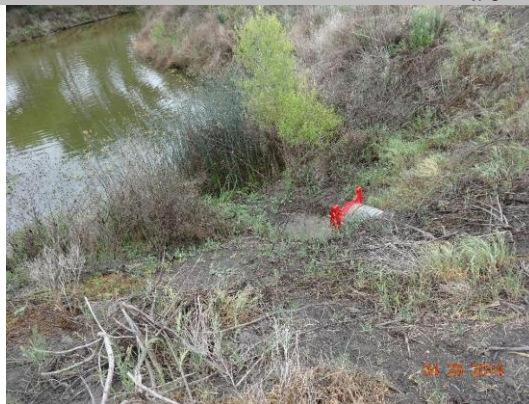
Photo 2 of 3 : UCIP\_SP\_2017\_39258\_66289.jpg

View of waterward side.

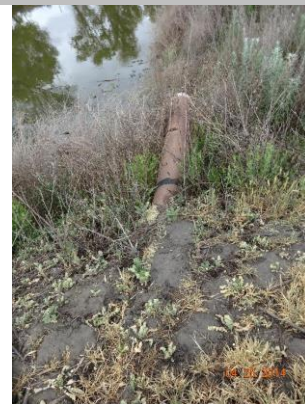
Photo 1 of 2 : UCIP\_SP\_2017\_39360\_71487.jpg

LM Start	16.72	Rating **	M	Issue No.	1248
LM End	16.72	Issue Type +	En	Location *	WS
Category	Supplemental			GPS Latitude/Longitude	
				Start	End
Item	DWR UCIP Field Study			37.224223 °	37.224223 °
				-120.783806 °	-120.783806 °
DWR ID					
Comment Code					
Inspector Comment					
FS_ID:39360 DS_ID:24870 EP_NO: N/A Repair Type: Non-Urgent Crossing Status: Found UCIP Comments: Need to contact owner to determine status and reason for crossing. FIELD_STRUCT_DESC: 12-inch steel pipe through the levee at an unknown depth. Concrete standpipe visible on landward side. FS Date: 4/25/2014

View of pipe located on waterward side.

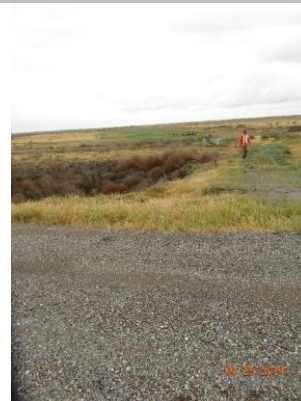
Photo 2 of 2 : UCIP\_SP\_2017\_39360\_71486.jpg

View of landward side.

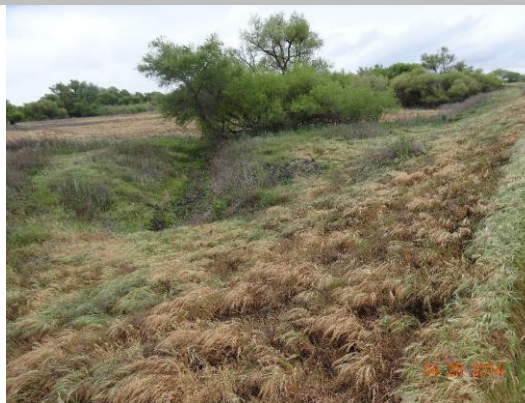
Photo 1 of 3 : UCIP\_SP\_2017\_39259\_65518.jpg

Comment Code						
Inspector Comment						
FS_ID:39259						
DS_ID:19577						
EP_NO: N/A						
Repair Type: Non-Urgent						
Crossing Status: Found						
UCIP Comments: Dense vegetation limits the inspector's visibility to identify signs of pipe failure (leaks) along the waterward and landward slopes. Concrete headwall is buried by dense vegetation. Recommend removing vegetation along pipe alignment to conduct proper inspection of structure.						
FIELD_STRUCT_DESC: 24-inch CM pipe through the levee, 11.5 feet below the crown. Flap gate on the waterward end. Brass cap No. 50 BM on headwall on the landward side. (USACE-1967). This entry matches the Drainage or Irrigation Structure referenced in O&M manual (HLM 17.01).						
FS Date: 4/25/2014

View of waterward side.

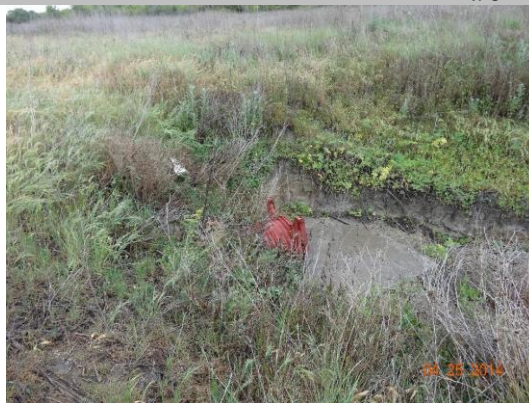
Photo 2 of 3 : UCIP\_SP\_2017\_39259\_65519.jpg

Flap gate visible on waterward side.

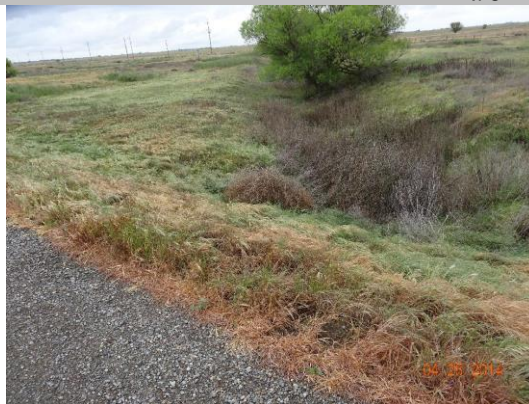
Photo 3 of 3 : UCIP\_SP\_2017\_39259\_65517.jpg

View of landward side.

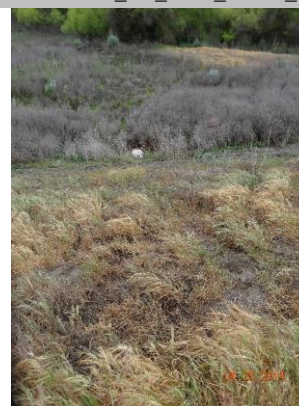
Photo 1 of 3 : UCIP\_SP\_2017\_39260\_65525.jpg

Comment Code					
Inspector Comment					
FS_ID:39260 DS_ID:19578 EP_NO: N/A Repair Type: Non-Urgent Crossing Status: Found UCIP Comments: Dense vegetation limits the inspector's visibility to identify signs of pipe failure (leaks) along the waterward and landward slopes. Recommend removing vegetation along pipe alignment to conduct proper inspection of structure. Sediment buildup inside pipe visible from landward side. Recommend clearing pipe. FIELD_STRUCT_DESC: 24-inch CM pipe through the levee, 11.5 feet below the crown. Flap gate on the waterward end. Brass cap No. 50 BM on headwall on the landward side. (USACE-1967). This entry matches the Drainage or Irrigation Structure referenced in O&M manual (HLM 17.19). FS Date: 4/25/2014

View of waterward side.

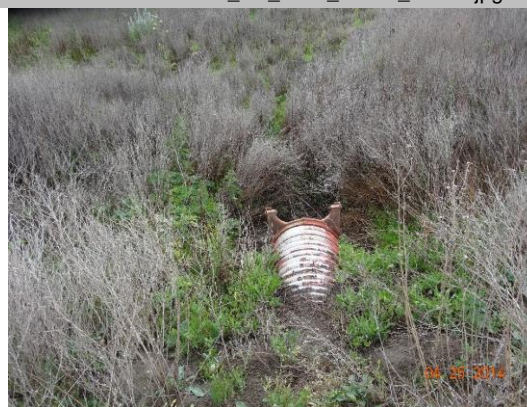
Photo 2 of 3 : UCIP\_SP\_2017\_39260\_65521.jpg

Pipe visible on waterward side.

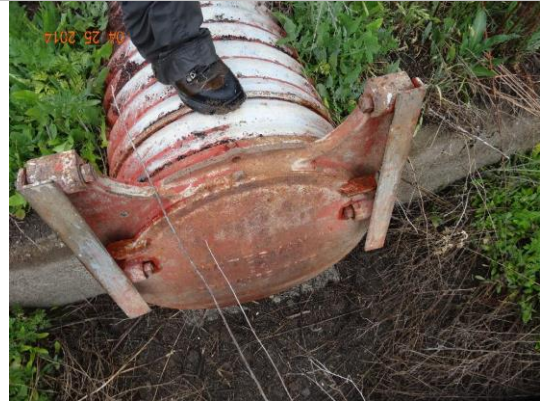
Photo 3 of 3 : UCIP\_SP\_2017\_39260\_65520.jpg

Flap gate visible on waterward toe.
