**Flood Control Project Maintenance  
Levee Inspections**  
**LMA District Cover Sheet**  
**Spring 2017 Levee Inspection Results**

**Lower San Joaquin Levee District**

Waterway			Bank	Unit Miles
Unit No. 01 San Joaquin River			Right	22.52
	Spring (March - May)	Summer (June - August)	(September - November) Fall	Winter (December - February)
Unit Maintenance Rating (Fall Only)				
Date of Inspection	4/17/2017 - 4/20/2017			
DWR Inspector	Richard Willoughby			
Accompanied By

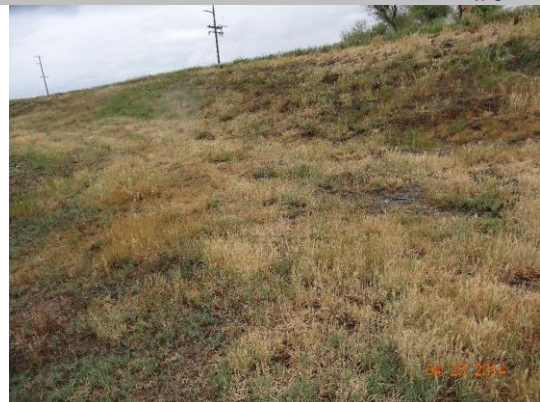
Photo 1 of 3 : UCIP\_SP\_2017\_36203\_65551.jpg

Comment Code						
Inspector Comment						
FS_ID:36203 DS_ID:19579 EP_NO: N/A Repair Type: Non-Urgent Crossing Status: Found UCIP Comments: Dense vegetation limits the inspector's visibility to identify signs of pipe failure (leaks) along the waterward and landward slope. Recommend removing vegetation along pipe alignment to conduct proper inspection of structure. FIELD_STRUCT_DESC: 24-inch CM pipe through the levee, 15.8 feet below the crown. Flap gate on the waterward end. Brass cap No. 50 BM on headwall on the landward side. (USACE-1967). This entry matches the Drainage or Irrigation Structure referenced in O&M manual (HLM 17.26). FS Date: 4/25/2014

View of waterward slope.

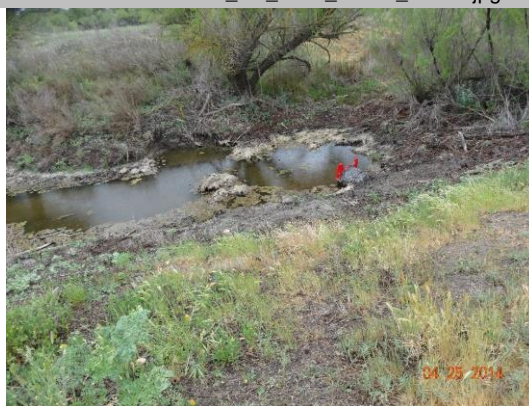
Photo 2 of 3 : UCIP\_SP\_2017\_36203\_65552.jpg

Item	DWR UCIP LMA Responsibility			37.218332 °		37.218332 °
				-120.779459 °		-120.779459 °
DWR ID						
Comment Code						
Inspector Comment						
FS_ID:36203 DS_ID:19579 EP_NO: N/A Repair Type: Non-Urgent Crossing Status: Found UCIP Comments: Dense vegetation limits the inspector's visibility to identify signs of pipe failure (leaks) along the waterward and landward slope. Recommend removing vegetation along pipe alignment to conduct proper inspection of structure. FIELD_STRUCT_DESC: 24-inch CM pipe through the levee, 15.8 feet below the crown. Flap gate on the waterward end. Brass cap No. 50 BM on headwall on the landward side. (USACE-1967). This entry matches the Drainage or Irrigation Structure referenced in O&M manual (HLM 17.26). FS Date: 4/25/2014

Pipe visible on waterward side.

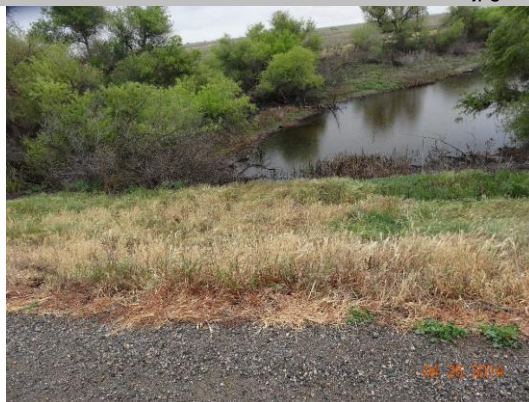
Photo 3 of 3 : UCIP\_SP\_2017\_36203\_65554.jpg

View of landward side.

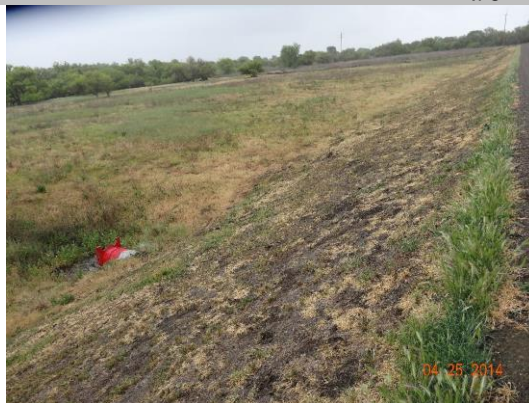
Photo 1 of 3 : UCIP\_SP\_2017\_36204\_65547.jpg

LM Start	17.52	Rating **	M	Issue No.	1252
LM End	17.52	Issue Type +	Ma	Location *	WS
Category	Supplemental			GPS Latitude/Longitude	
				Start	End
Item	DWR UCIP LMA Responsibility			37.215976 °	37.215976 °
				-120.777615 °	-120.777615 °
DWR ID					
Comment Code					
Inspector Comment					
FS_ID:36204 DS_ID:19580 EP_NO: N/A Repair Type: Non-Urgent Crossing Status: Found UCIP Comments: Dense vegetation limits the inspector's visibility to identify signs of pipe failure (leaks) along the landward slope. Recommend removing vegetation along pipe alignment to conduct proper inspection of structure. FIELD_STRUCT_DESC: 24-inch CM pipe through the levee, 9.5 feet below the crown. Flap gate on the waterward end. Brass cap No. 50 BM on headwall on the landward side. (USACE-1967). This entry matches the Drainage or Irrigation Structure referenced in O&M manual (HLM 17.53). FS Date: 4/25/2014

View of waterward side.

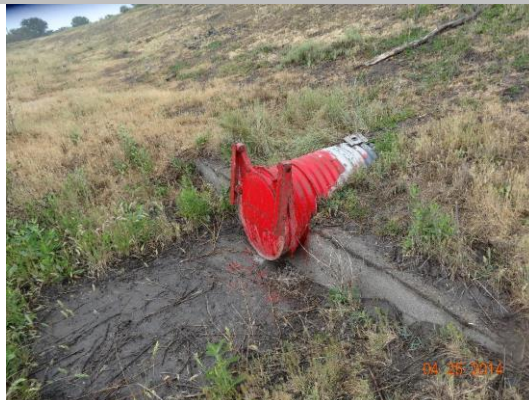
Photo 2 of 3 : UCIP\_SP\_2017\_36204\_65546.jpg

Flap gate visible on waterward side.

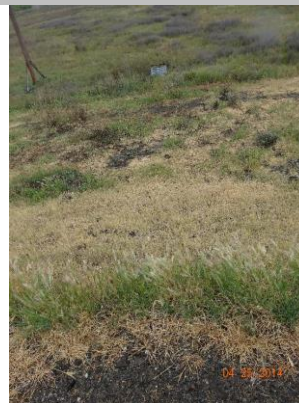
Photo 3 of 3 : UCIP\_SP\_2017\_36204\_65545.jpg

Item	DWR UCIP LMA Responsibility			37.215976 °		37.215976 °
				-120.777615 °		-120.777615 °
DWR ID						
Comment Code						
Inspector Comment						
FS_ID:36204 DS_ID:19580 EP_NO: N/A Repair Type: Non-Urgent Crossing Status: Found UCIP Comments: Dense vegetation limits the inspector's visibility to identify signs of pipe failure (leaks) along the landward slope. Recommend removing vegetation along pipe alignment to conduct proper inspection of structure. FIELD_STRUCT_DESC: 24-inch CM pipe through the levee, 9.5 feet below the crown. Flap gate on the waterward end. Brass cap No. 50 BM on headwall on the landward side. (USACE-1967). This entry matches the Drainage or Irrigation Structure referenced in O&M manual (HLM 17.53). FS Date: 4/25/2014

View of landward side--riser at levee toe.

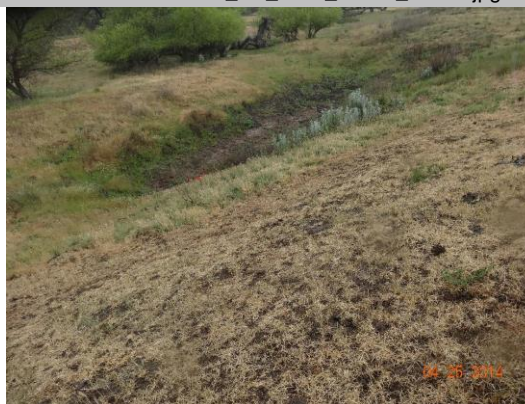
Photo 1 of 3 : UCIP\_SP\_2017\_39261\_65557.jpg

LM Start	18.18	Rating **	M	Issue No.	1253
LM End	18.18	Issue Type +	Ma	Location *	WS
Category	Supplemental			GPS Latitude/Longitude	
				Start	End
Item	DWR UCIP LMA Responsibility			37.210998 °	37.210998 °
				-120.768900 °	-120.768900 °
DWR ID					
Comment Code					
Inspector Comment					
FS_ID:39261 DS_ID:19581 EP_NO: N/A Repair Type: Non-Urgent Crossing Status: Found UCIP Comments: Need to contact owner. Recommend investigating integrity of pipe wall through levee heavy corrosion visible from landward side. FIELD_STRUCT_DESC: 24-inch CM pipe through the levee, 11.5 feet below the crown. Flap gate on the waterward end. Brass cap No. 50 BM on headwall on the landward side. (USACE-1967). This entry matches the Drainage or Irrigation Structure referenced in O&M manual (HLM 18.19). FS Date: 4/25/2014

View of waterward side.

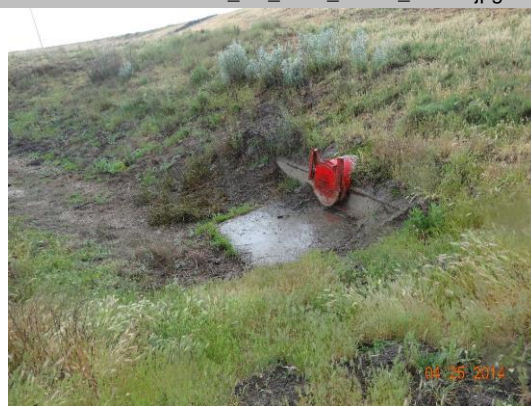
Photo 2 of 3 : UCIP\_SP\_2017\_39261\_65556.jpg

LM Start	18.18	Rating **	M	Issue No.	1253 (cont)	
LM End	18.18	Issue Type +	Ma	Location *	WS	
Category	Supplemental			GPS Latitude/Longitude		
				Start		End
Item	DWR UCIP LMA Responsibility			37.210998 °		37.210998 °
				-120.768900 °		-120.768900 °
DWR ID						
Comment Code						
Inspector Comment						
FS_ID:39261 DS_ID:19581 EP_NO: N/A Repair Type: Non-Urgent Crossing Status: Found UCIP Comments: Need to contact owner. Recommend investigating integrity of pipe wall through levee heavy corrosion visible from landward side. FIELD_STRUCT_DESC: 24-inch CM pipe through the levee, 11.5 feet below the crown. Flap gate on the waterward end. Brass cap No. 50 BM on headwall on the landward side. (USACE-1967). This entry matches the Drainage or Irrigation Structure referenced in O&M manual (HLM 18.19). FS Date: 4/25/2014

Flap gate visible on waterward side.

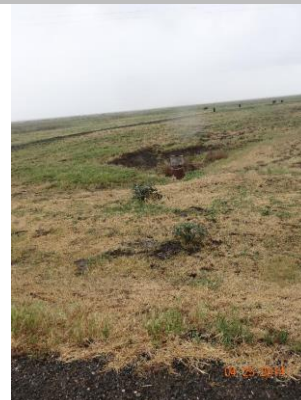
Photo 3 of 3 : UCIP\_SP\_2017\_39261\_65555.jpg

View of landward side.

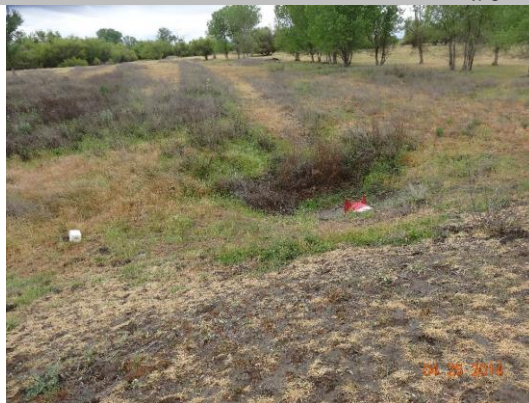
Photo 1 of 3 : UCIP\_SP\_2017\_36206\_65563.jpg

LM Start	18.45	Rating **	A/W	Issue No.	1254
LM End	18.45	Issue Type +	Ma	Location *	WS
Category	Supplemental			GPS Latitude/Longitude	
				Start	End
Item	DWR UCIP LMA Responsibility			37.207538 °	37.207538 °
				-120.767679 °	-120.767679 °
DWR ID					
Comment Code					
Inspector Comment					
FS_ID:36206 DS_ID:19582 EP_NO: N/A Repair Type: No Action Needed Crossing Status: Found UCIP Comments: FIELD_STRUCT_DESC: 24-inch CM pipe through the levee, 9.4 feet below the crown. Flap gate on the waterward end. Brass cap No. 50 BM on headwall on the landward side. (USACE-1967). This entry matches the Drainage or Irrigation Structure referenced in O&M manual (HLM 18.45). FS Date: 4/25/2014

View of waterward side.

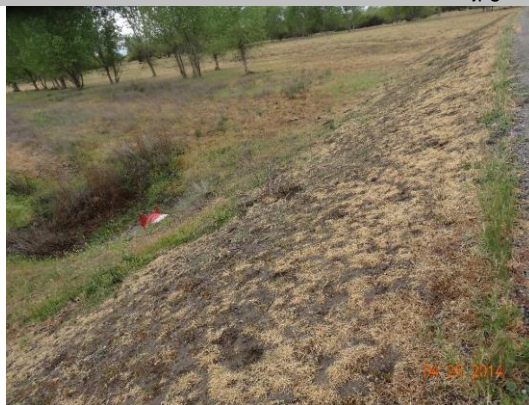
Photo 2 of 3 : UCIP\_SP\_2017\_36206\_65562.jpg

View of waterward slope.

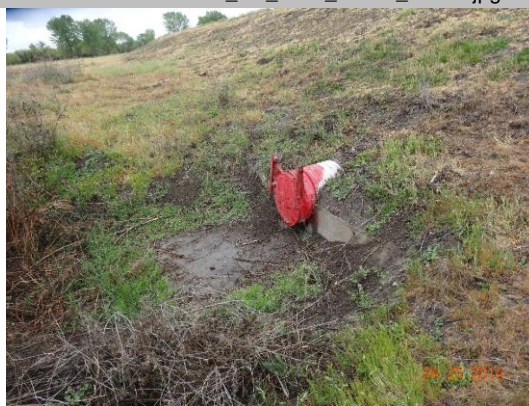
Photo 3 of 3 : UCIP\_SP\_2017\_36206\_65561.jpg

LM Start	18.45	Rating **	A/W	Issue No.	1254 (cont)
LM End	18.45	Issue Type +	Ma	Location *	WS
Category	Supplemental			GPS Latitude/Longitude	
				Start	End
Item	DWR UCIP LMA Responsibility			37.207538 °	37.207538 °
				-120.767679 °	-120.767679 °
DWR ID					
Comment Code					
Inspector Comment					
FS_ID:36206 DS_ID:19582 EP_NO: N/A Repair Type: No Action Needed Crossing Status: Found UCIP Comments: FIELD_STRUCT_DESC: 24-inch CM pipe through the levee, 9.4 feet below the crown. Flap gate on the waterward end. Brass cap No. 50 BM on headwall on the landward side. (USACE-1967). This entry matches the Drainage or Irrigation Structure referenced in O&M manual (HLM 18.45). FS Date: 4/25/2014

Flap gate visible on waterward side.

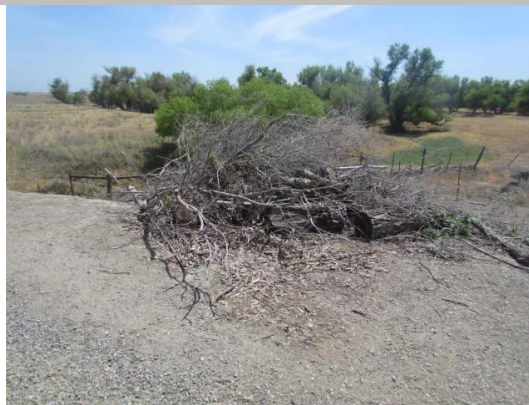
Photo 1 of 1 : SP\_2017\_NA0010\_118\_27\_20170417\_00018.jpg

LM Start	18.77	Rating **	M	Issue No.	27
LM End	18.77	Issue Type +	En	Location *	WS
Category	Earthen Levee			GPS Latitude/Longitude	
				Start	End
Item	Encroachments			37.205080 °	37.205080 °
				-120.762655 °	-120.762655 °
DWR ID	DWR_NA0010_01_s_2014_27				
Comment Code					
PR : Prunings					
Inspector Comment

Looking at prunings on waterward shoulder and slope.

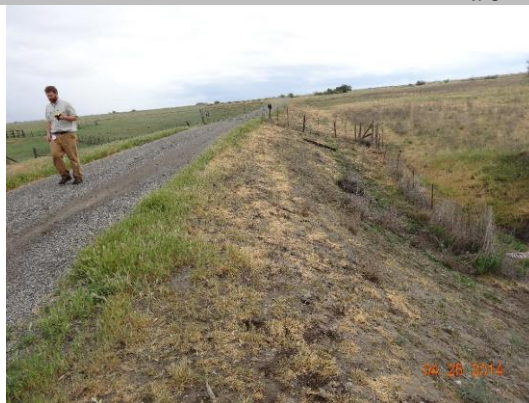
Photo 1 of 3 : UCIP\_SP\_2017\_36246\_65627.jpg

LM Start	18.79	Rating **	M	Issue No.	1255
LM End	18.79	Issue Type +	Ma	Location *	WS
Category	Supplemental			GPS Latitude/Longitude	
				Start	End
Item	DWR UCIP LMA Responsibility			37.204966 °	37.204966 °
				-120.762511 °	-120.762511 °
DWR ID					
Comment Code					
Inspector Comment					
FS_ID:36246 DS_ID:19593 EP_NO: N/A Repair Type: Non-Urgent Crossing Status: Found UCIP Comments: Dense vegetation limits the inspector's visibility to identify signs of pipe failure (leaks) along the landward slope. Recommend removing vegetation along pipe alignment to conduct proper inspection of structure. FIELD_STRUCT_DESC: 24-inch CM pipe through the levee, 12.0 feet below the crown. Flap gate on the waterward end. Brass cap No. 50 BM on headwall on the landward side. (USACE-1967). This entry matches the Drainage or Irrigation Structure referenced in O&M manual (HLM 18.79). FS Date: 4/25/2014

Overview of levee crown and waterward slope.

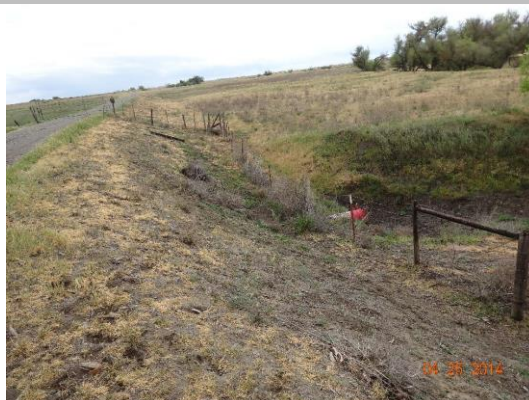
Photo 2 of 3 : UCIP\_SP\_2017\_36246\_65623.jpg

View of waterward side.

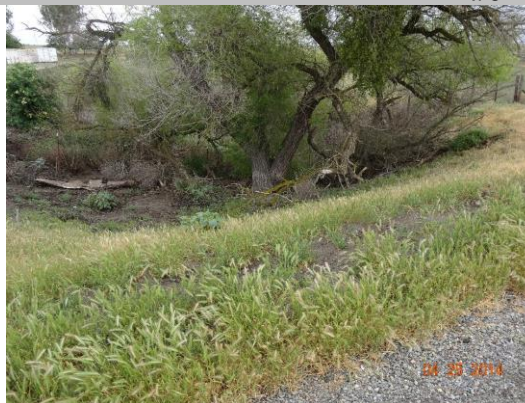
Photo 3 of 3 : UCIP\_SP\_2017\_36246\_65626.jpg

Item	DWR UCIP LMA Responsibility			37.204966 °	37.204966 °	
				-120.762511 °	-120.762511 °	
DWR ID						
Comment Code						
Inspector Comment						
FS_ID:36246 DS_ID:19593 EP_NO: N/A Repair Type: Non-Urgent Crossing Status: Found UCIP Comments: Dense vegetation limits the inspector's visibility to identify signs of pipe failure (leaks) along the landward slope. Recommend removing vegetation along pipe alignment to conduct proper inspection of structure. FIELD_STRUCT_DESC: 24-inch CM pipe through the levee, 12.0 feet below the crown. Flap gate on the waterward end. Brass cap No. 50 BM on headwall on the landward side. (USACE-1967). This entry matches the Drainage or Irrigation Structure referenced in O&M manual (HLM 18.79). FS Date: 4/25/2014

Overview of landward side.

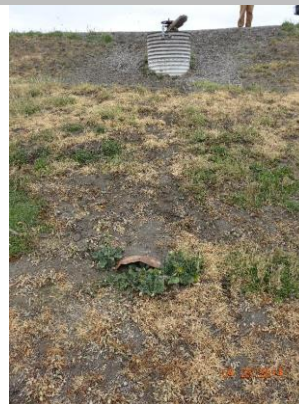
Photo 1 of 3 : UCIP\_SP\_2017\_39263\_65631.jpg

Comment Code					
Inspector Comment					
FS_ID:39263 DS_ID:19594 EP_NO: N/A Repair Type: Non-Urgent Crossing Status: Found UCIP Comments: Non-functional crossing--pipe is buried on waterward side. Sediment buildup in pipe visible from landward side. Need to coordinate with owner to determine status. If crossing is no longer in use, owner will need to coordinate with DWR Inspector and CVFPB to properly abandon. FIELD_STRUCT_DESC: 24-inch CM pipe through the levee, 13.0 feet below the crown. Slide gate on the waterward slope. Brass cap No. 40 BM on headwall on the landward side. (USACE-1967). This entry matches the Drainage or Irrigation Structure referenced in O&M manual (HLM 19.17). FS Date: 4/25/2014

View of waterward slope. CMP riser and pipe visible.

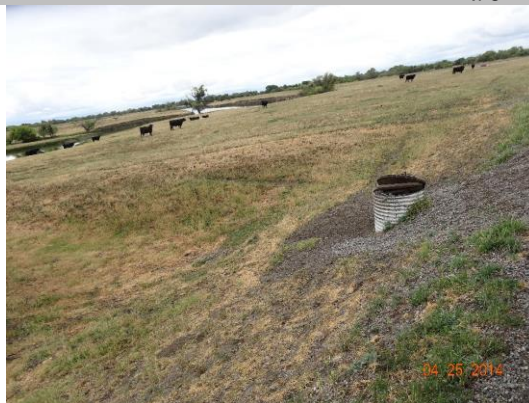
Photo 2 of 3 : UCIP\_SP\_2017\_39263\_65630.jpg

Item	DWR UCIP LMA Responsibility			37.202801 °	37.202801 °	
				-120.756209 °	-120.756209 °	
DWR ID						
Comment Code						
Inspector Comment						
FS_ID:39263 DS_ID:19594 EP_NO: N/A Repair Type: Non-Urgent Crossing Status: Found UCIP Comments: Non-functional crossing--pipe is buried on waterward side. Sediment buildup in pipe visible from landward side. Need to coordinate with owner to determine status. If crossing is no longer in use, owner will need to coordinate with DWR Inspector and CVFPB to properly abandon. FIELD_STRUCT_DESC: 24-inch CM pipe through the levee, 13.0 feet below the crown. Slide gate on the waterward slope. Brass cap No. 40 BM on headwall on the landward side. (USACE-1967). This entry matches the Drainage or Irrigation Structure referenced in O&M manual (HLM 19.17). FS Date: 4/25/2014

View of waterward side.

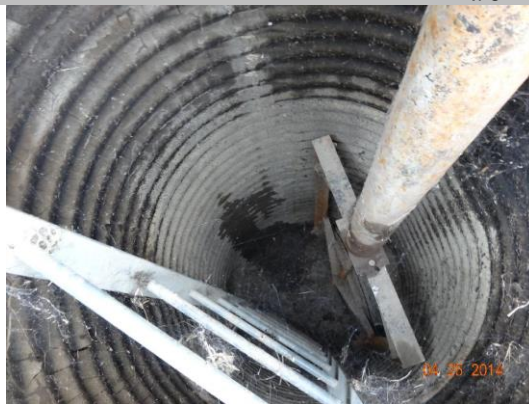
Photo 3 of 3 : UCIP\_SP\_2017\_39263\_65632.jpg

Inside view of CMP riser.

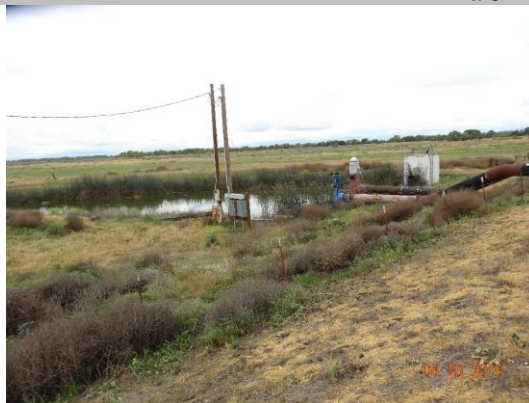
Photo 1 of 3 : UCIP\_SP\_2017\_39266\_71421.jpg

LM Start	19.32	Rating **	M	Issue No.	1257
LM End	19.32	Issue Type +	En	Location *	WS
Category	Supplemental			GPS Latitude/Longitude	
				Start	End
Item	DWR UCIP Field Study			37.200921 °	37.200921 °
				-120.756901 °	-120.756901 °
DWR ID					
Comment Code					
Inspector Comment					
FS_ID:39266					
DS_ID:24871					
EP_NO: N/A					
Repair Type: Non-Urgent					
Crossing Status: Found					
UCIP Comments: New crossing found during field inspection--Need to contact owner to obtain additional information about crossing.					
FIELD_STRUCT_DESC: 1 of 2: 20-inch steel pipe through levee at an unknown depth. Pump station located on landward side. Electrical panel located on landward side.					
FS Date: 4/25/2014

View of landward side.

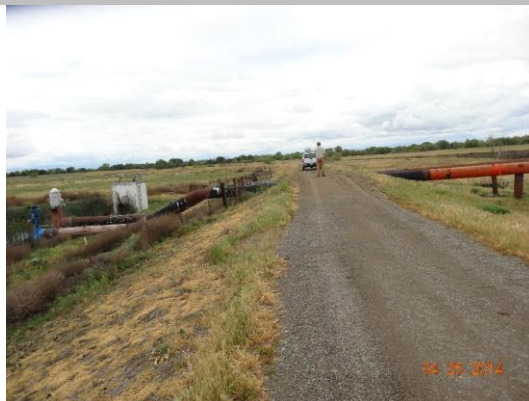
Photo 2 of 3 : UCIP\_SP\_2017\_39266\_71420.jpg

Overview of levee crown at crossing.

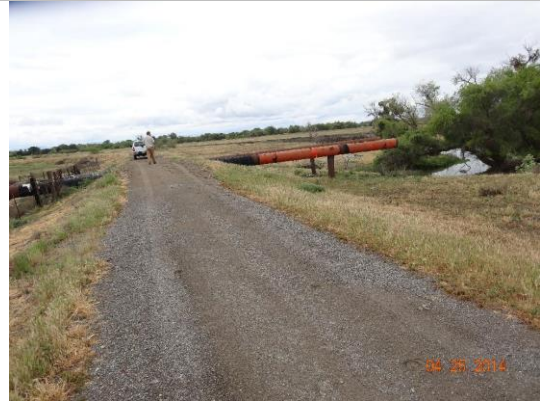
Photo 3 of 3 : UCIP\_SP\_2017\_39266\_71423.jpg

LM Start	19.32	Rating **	M	Issue No.	1257 (cont)
LM End	19.32	Issue Type +	En	Location *	WS
Category	Supplemental			GPS Latitude/Longitude	
				Start	End
Item	DWR UCIP Field Study			37.200921 °	37.200921 °
				-120.756901 °	-120.756901 °
DWR ID					
Comment Code					
Inspector Comment					
FS_ID:39266 DS_ID:24871 EP_NO: N/A Repair Type: Non-Urgent Crossing Status: Found UCIP Comments: New crossing found during field inspection--Need to contact owner to obtain additional information about crossing. FIELD_STRUCT_DESC: 1 of 2: 20-inch steel pipe through levee at an unknown depth. Pump station located on landward side. Electrical panel located on landward side. FS Date: 4/25/2014

View of waterward slope.

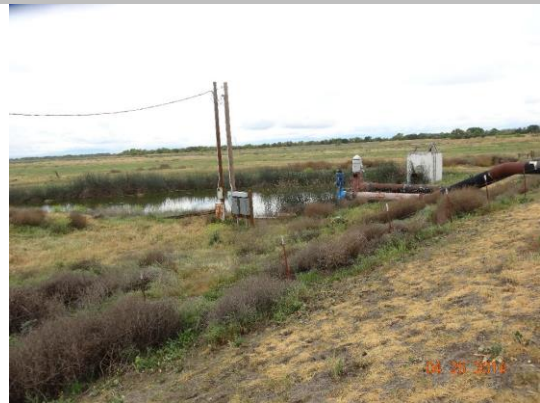
Photo 1 of 3 : UCIP\_SP\_2017\_39267\_71427.jpg

LM Start	19.32	Rating **	M	Issue No.	1258
LM End	19.32	Issue Type +	En	Location *	WS
Category	Supplemental			GPS Latitude/Longitude	
				Start	End
Item	DWR UCIP Field Study			37.200919 °	37.200919 °
				-120.756928 °	-120.756928 °
DWR ID					
Comment Code					
Inspector Comment					
FS_ID:39267 DS_ID:24872 EP_NO: N/A Repair Type: Non-Urgent Crossing Status: Found UCIP Comments: New crossing found during field inspection--Need to contact owner to obtain additional information about crossing. FIELD_STRUCT_DESC: 2 of 2: 20-inch steel pipe through levee at an unknown depth. Pump station located on landward side. Electrical panel located on landward side. FS Date: 4/25/2014

View of landward side.

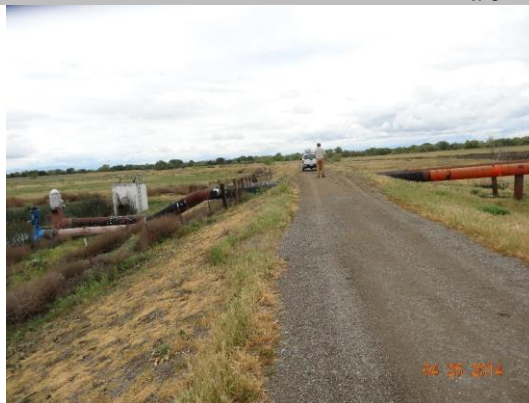
Photo 2 of 3 : UCIP\_SP\_2017\_39267\_71425.jpg

LM Start	19.32	Rating **	M	Issue No.	1258 (cont)
LM End	19.32	Issue Type +	En	Location *	WS
Category	Supplemental			GPS Latitude/Longitude	
				Start	End
Item	DWR UCIP Field Study			37.200919 °	37.200919 °
				-120.756928 °	-120.756928 °
DWR ID					
Comment Code					
Inspector Comment					
FS_ID:39267					
DS_ID:24872					
EP_NO: N/A					
Repair Type: Non-Urgent					
Crossing Status: Found					
UCIP Comments: New crossing found during field inspection--Need to contact owner to obtain additional information about crossing.					
FIELD_STRUCT_DESC: 2 of 2: 20-inch steel pipe through levee at an unknown depth. Pump station located on landward side. Electrical panel located on landward side.					
FS Date: 4/25/2014

View of levee crown at crossings.

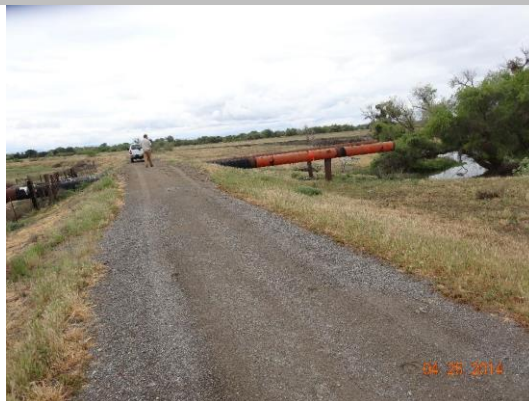
Photo 3 of 3 : UCIP\_SP\_2017\_39267\_71424.jpg

View of waterward slope.

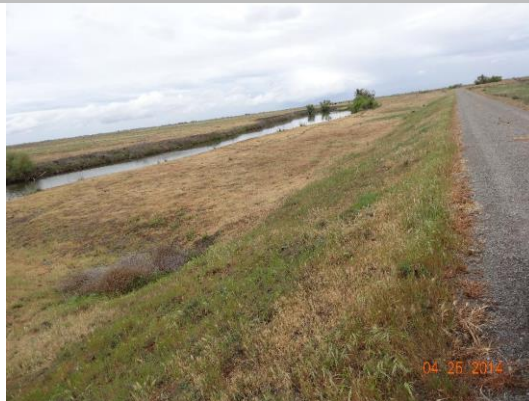
Photo 1 of 3 : UCIP\_SP\_2017\_39268\_65641.jpg

Comment Code						
Inspector Comment						
FS_ID:39268 DS_ID:19596 EP_NO: N/A Repair Type: Non-Urgent Crossing Status: Found UCIP Comments: Dense vegetation limits the inspector's visibility to identify signs of pipe failure (leaks) along the waterward slope. Recommend removing vegetation along pipe alignment to conduct proper inspection of structure. Dense vegetation blocks both waterward and landward headwalls. Sediment buildup in pipe visible from landward side. FIELD_STRUCT_DESC: 24-inch CM pipe through the levee, 8.0 feet below the crown. Flap gate on the waterward end. Brass cap No. 40 BM on headwall on the landward side. (USACE-1967). This entry matches the Drainage or Irrigation Structure referenced in O&M manual (HLM 19.54). FS Date: 4/25/2014

View of waterward side.

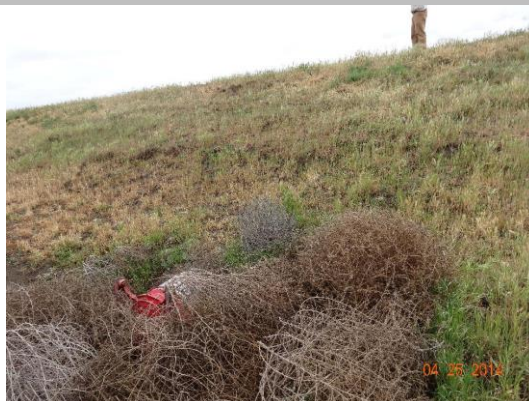
Photo 2 of 3 : UCIP\_SP\_2017\_39268\_65640.jpg

Flap gate visible on waterward side--potential erosion present on slope.

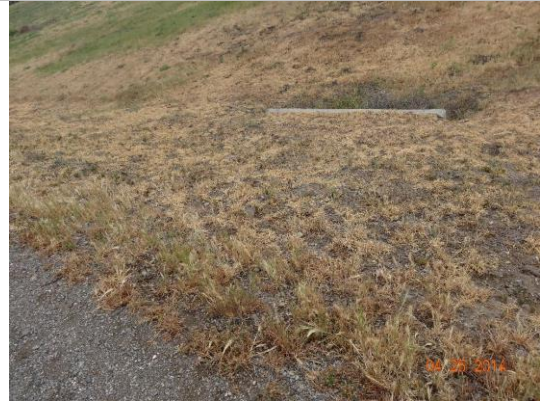
Photo 3 of 3 : UCIP\_SP\_2017\_39268\_65639.jpg

Item	DWR UCIP LMA Responsibility			37.199427 °		37.199427 °
				-120.760235 °		-120.760235 °
DWR ID						
Comment Code						
Inspector Comment						
FS_ID:39268 DS_ID:19596 EP_NO: N/A Repair Type: Non-Urgent Crossing Status: Found UCIP Comments: Dense vegetation limits the inspector's visibility to identify signs of pipe failure (leaks) along the waterward slope. Recommend removing vegetation along pipe alignment to conduct proper inspection of structure. Dense vegetation blocks both waterward and landward headwalls. Sediment buildup in pipe visible from landward side. FIELD_STRUCT_DESC: 24-inch CM pipe through the levee, 8.0 feet below the crown. Flap gate on the waterward end. Brass cap No. 40 BM on headwall on the landward side. (USACE-1967). This entry matches the Drainage or Irrigation Structure referenced in O&M manual (HLM 19.54). FS Date: 4/25/2014

View of landward slope.

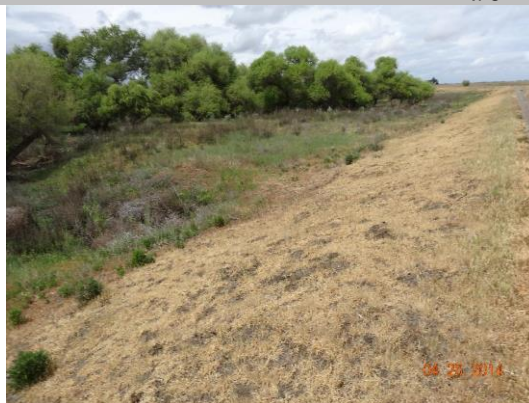
Photo 1 of 3 : UCIP\_SP\_2017\_39269\_65648.jpg

LM Start	20.18	Rating **	M	Issue No.	1261
LM End	20.18	Issue Type +	Ma	Location *	WS
Category	Supplemental			GPS Latitude/Longitude	
				Start	End
Item	DWR UCIP LMA Responsibility			37.194669 °	37.194669 °
				-120.759736 °	-120.759736 °
DWR ID					
Comment Code					
Inspector Comment					
FS_ID:39269 DS_ID:19598 EP_NO: N/A Repair Type: Non-Urgent Crossing Status: Found UCIP Comments: Recommend removing vegetation and sediment buildup from both waterward and landward concrete headwalls. FIELD_STRUCT_DESC: 24-inch CM pipe through the levee, 8.5 feet below the crown. Flap gate on the waterward end. Brass cap No. 40 BM on headwall on the landward side. (USACE-1967). This entry matches the Drainage or Irrigation Structure referenced in O&M manual (HLM 20.18). FS Date: 4/25/2014

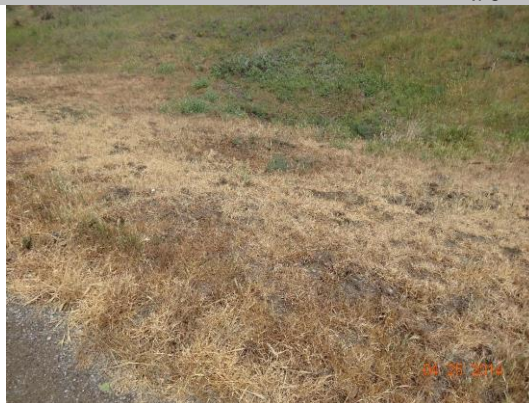
Photo 3 of 3 : UCIP\_SP\_2017\_39269\_65646.jpg

LM Start	20.18	Rating **	M	Issue No.	1261 (cont)	
LM End	20.18	Issue Type +	Ma	Location *	WS	
Category	Supplemental			GPS Latitude/Longitude		
				Start		End
Item	DWR UCIP LMA Responsibility			37.194669 °		37.194669 °
				-120.759736 °		-120.759736 °
DWR ID						
Comment Code						
Inspector Comment						
FS_ID:39269 DS_ID:19598 EP_NO: N/A Repair Type: Non-Urgent Crossing Status: Found UCIP Comments: Recommend removing vegetation and sediment buildup from both waterward and landward concrete headwalls. FIELD_STRUCT_DESC: 24-inch CM pipe through the levee, 8.5 feet below the crown. Flap gate on the waterward end. Brass cap No. 40 BM on headwall on the landward side. (USACE-1967). This entry matches the Drainage or Irrigation Structure referenced in O&M manual (HLM 20.18). FS Date: 4/25/2014

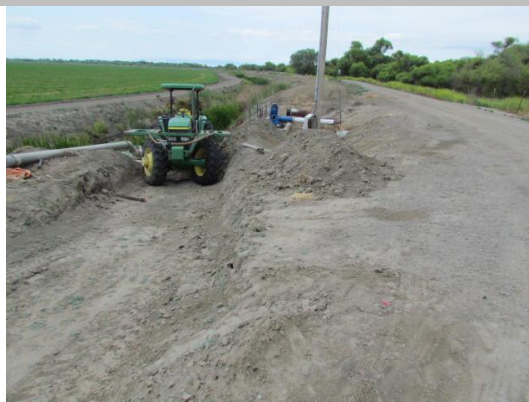
Photo 1 of 2 : SP\_2017\_NA0010\_118\_1184\_20170417\_00032.jpg

LM Start	20.25	Rating **	U	Issue No.	1184
LM End	20.25	Issue Type +	En	Location *	LS
Category	Earthen Levee			GPS Latitude/Longitude	
				Start	End
Item	Encroachments			37.193657 °	37.193657 °
				-120.760138 °	-120.760138 °
DWR ID	DWR_NA0010_01_s_2015_1184				
Comment Code					
RA : Ramp					
Inspector Comment					
Landowner installed unauthorized ramp on landward slope and toe.

Looking north at ramp cut into landward slope.

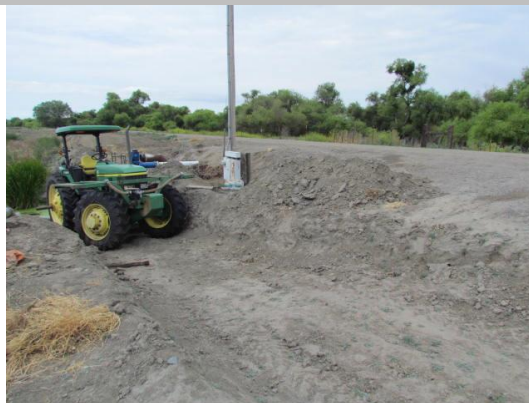
Photo 2 of 2 : SP\_2017\_NA0010\_118\_1184\_20170417\_00033.jpg

LM Start	20.25	Rating **	U	Issue No.	1184 (cont)	
LM End	20.25	Issue Type +	En	Location *	LS	
Category	Earthen Levee			GPS Latitude/Longitude		
				Start		End
Item	Encroachments			37.193657 °	37.193657 °	
				-120.760138 °	-120.760138 °	
DWR ID	DWR_NA0010_01_s_2015_1184					
Comment Code						
RA : Ramp						
Inspector Comment						
Landowner installed unauthorized ramp on landward slope and toe.

Looking east at ramp cut into landward slope.

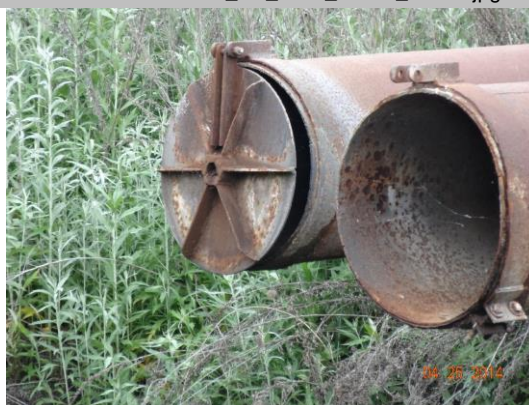
Photo 1 of 3 : UCIP\_SP\_2017\_39285\_71446.jpg

LM Start	20.26	Rating **	M	Issue No.	1262
LM End	20.26	Issue Type +	En	Location *	LS
Category	Supplemental			GPS Latitude/Longitude	
				Start	End
Item	DWR UCIP Field Study			37.193550 °	37.193550 °
				-120.760284 °	-120.760284 °
DWR ID					
Comment Code					
Inspector Comment					
FS_ID:39285					
DS_ID:24873					
EP_NO: N/A					
Repair Type: Non-Urgent					
Crossing Status: Found					
UCIP Comments: Dense vegetation limits the inspector's visibility to identify signs of pipe failure (leaks) along the waterward slope.					
Recommend removing vegetation along pipe alignment to conduct proper inspection of structure.					
FIELD_STRUCT_DESC: 12-inch steel sleeved into a 24-inch steel pipe through levee at an unknown depth.					
FS Date: 4/25/2014

Outlet visible on waterward side.

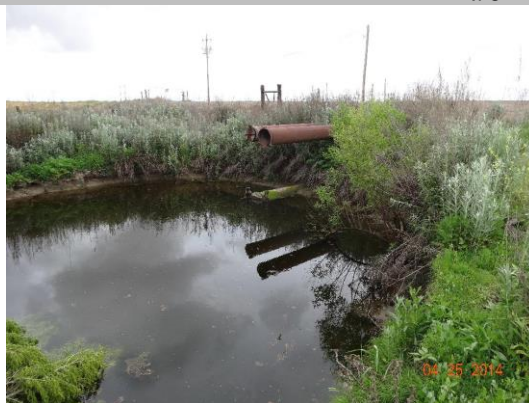
Photo 2 of 3 : UCIP\_SP\_2017\_39285\_71445.jpg

LM Start	20.26	Rating **	M	Issue No.	1262 (cont)
LM End	20.26	Issue Type +	En	Location *	LS
Category	Supplemental	GPS Latitude/Longitude			
		Start	End	Start	End
Item	DWR UCIP Field Study	37.193550 °	37.193550 °	-120.760284 °	-120.760284 °
		-120.760284 °	-120.760284 °		
DWR ID					
Comment Code					
Inspector Comment					
FS_ID:39285 DS_ID:24873 EP_NO: N/A Repair Type: Non-Urgent Crossing Status: Found UCIP Comments: Dense vegetation limits the inspector's visibility to identify signs of pipe failure (leaks) along the waterward slope. Recommend removing vegetation along pipe alignment to conduct proper inspection of structure. FIELD_STRUCT_DESC: 12-inch steel sleeved into a 24-inch steel pipe through levee at an unknown depth. FS Date: 4/25/2014

View of waterward side.

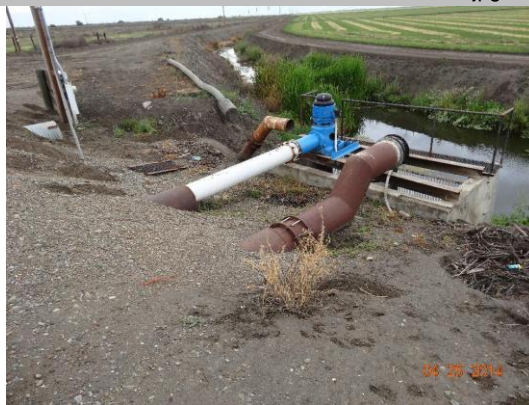
Photo 3 of 3 : UCIP\_SP\_2017\_39285\_71444.jpg

View of landward side.

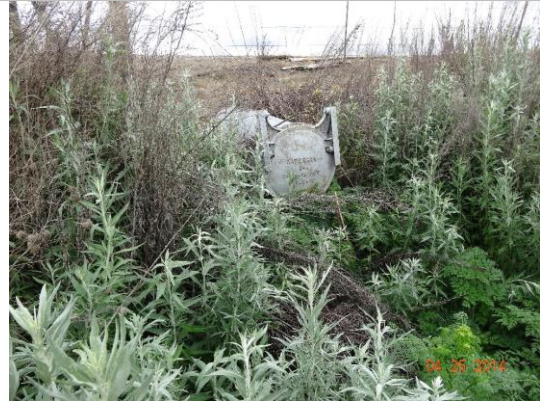
Photo 3 of 3 : UCIP\_SP\_2017\_49965\_66302.jpg

Item	DWR UCIP Field Study			37.193542 °		37.193542 °
				-120.760300 °		-120.760300 °
DWR ID						
Comment Code						
Inspector Comment						
FS_ID:49965						
DS_ID:19599						
EP_NO: N/A						
Repair Type: Non-Urgent						
Crossing Status: Found						
UCIP Comments: 7/19/2016 same as previous inspection. crossing						
was downgraded from Urgent to Non-Urgent due to metal rod not						
interfering with flap gate. (DWR UCIP - omagana)4/25/2014						
Unauthorized crossing through pipe. Line was pushed through existing						
crossing. Need to contact owner. Also sediment buildup in pipe visible						
from landward side--recommend clearing. (DWR UCIP - omagana)						
FIELD_STRUCT_DESC: 24-inch corrugated metal pipe through the						
levee, 5 feet below the crown. Flap gate located on the waterside (WS)						
end. [Additional Reference(s): DWR Levee Log, 2002]						
FS Date: 7/19/2016

View of WS.

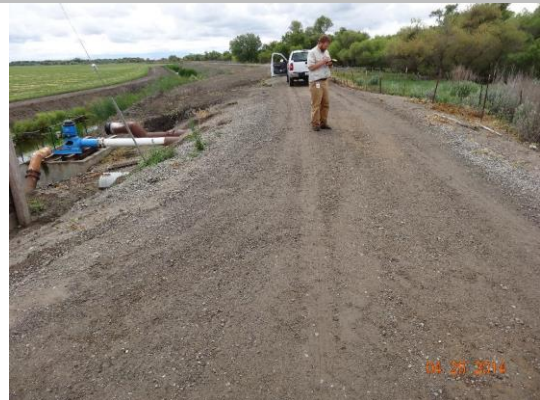
Photo 1 of 3 : UCIP\_SP\_2017\_39878\_66308.jpg

LM Start	20.27	Rating **	M	Issue No.	1264
LM End	20.27	Issue Type +	Ma	Location *	LS
Category	Supplemental			GPS Latitude/Longitude	
				Start	End
Item	DWR UCIP LMA Responsibility			37.193542 °	37.193542 °
				-120.760300 °	-120.760300 °
DWR ID					
Comment Code					
Inspector Comment					
FS_ID:39878 DS_ID:19600 EP_NO: N/A Repair Type: Non-Urgent Crossing Status: Found UCIP Comments: Crossing partially submersed--no signs of failure of pipe present along pipe alignment. Recommend contacting owner to determine status of crossing and condition. FIELD_STRUCT_DESC: 36-inch CM pipe through the levee, 10.5 feet below the crown. Flap gate on the waterward end. Brass cap No. 40 BM on headwall on the landward side. (USACE-1967). This entry matches the Drainage or Irrigation Structure referenced in O&M manual (HLM 20.27). FS Date: 4/25/2014

Overview of levee crown at crossing--multiple crossings at this location.

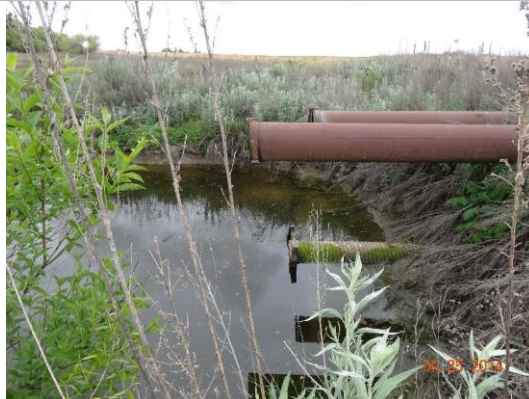
Photo 2 of 3 : UCIP\_SP\_2017\_39878\_66309.jpg

Item	DWR UCIP LMA Responsibility			37.193542 °		37.193542 °
				-120.760300 °		-120.760300 °
DWR ID						
Comment Code						
Inspector Comment						
FS_ID:39878						
DS_ID:19600						
EP_NO: N/A						
Repair Type: Non-Urgent						
Crossing Status: Found						
UCIP Comments: Crossing partially submersed--no signs of failure of pipe present along pipe alignment. Recommend contacting owner to determine status of crossing and condition.						
FIELD_STRUCT_DESC: 36-inch CM pipe through the levee, 10.5 feet below the crown. Flap gate on the waterward end. Brass cap No. 40 BM on headwall on the landward side. (USACE-1967). This entry matches the Drainage or Irrigation Structure referenced in O&M manual (HLM 20.27).						
FS Date: 4/25/2014

Multiple crossings visible on waterward side--36 inch CMP is submersed in water.

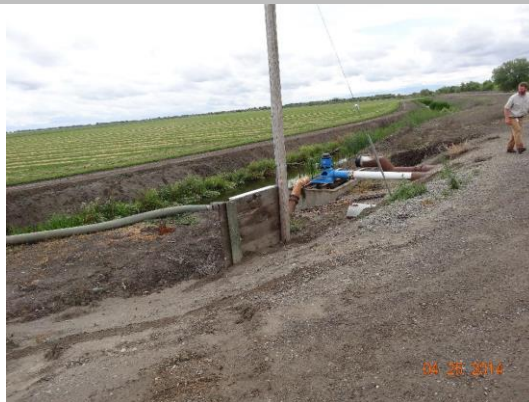
Photo 3 of 3 : UCIP\_SP\_2017\_39878\_66307.jpg

View of landward side.

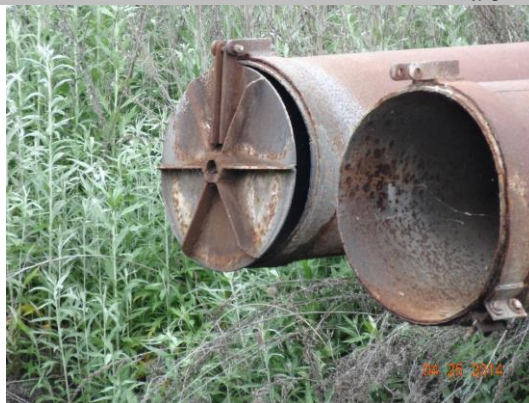
Photo 1 of 3 : UCIP\_SP\_2017\_39286\_71442.jpg

LM Start	20.27	Rating **	M	Issue No.	1265
LM End	20.27	Issue Type +	En	Location *	LS
Category	Supplemental			GPS Latitude/Longitude	
				Start	End
Item	DWR UCIP Field Study			37.193542 °	37.193542 °
				-120.760300 °	-120.760300 °
DWR ID					
Comment Code					
Inspector Comment					
FS_ID:39286					
DS_ID:24874					
EP_NO: N/A					
Repair Type: Non-Urgent					
Crossing Status: Found					
UCIP Comments: Dense vegetation limits the inspector's visibility to identify signs of pipe failure (leaks) along the waterward slope.					
Recommend removing vegetation along pipe alignment to conduct proper inspection of structure.					
FIELD_STRUCT_DESC: 18-inch steel sleeved into a 24-inch steel pipe through levee at an unknown depth.					
FS Date: 4/25/2014

Outlets visible on waterward side.

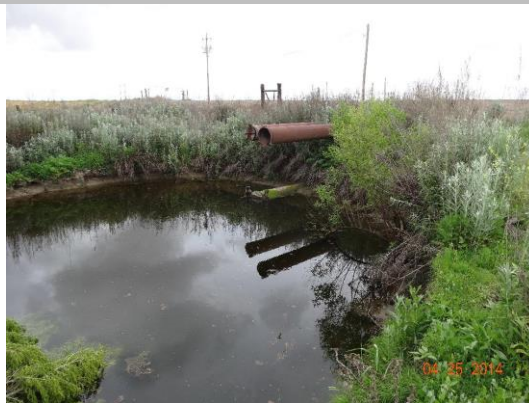
Photo 2 of 3 : UCIP\_SP\_2017\_39286\_71441.jpg

View of waterward side.

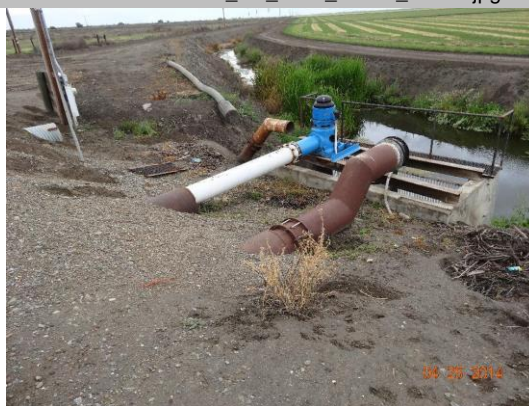
Photo 3 of 3 : UCIP\_SP\_2017\_39286\_71440.jpg

LM Start	20.27	Rating **	M	Issue No.	1265 (cont)	
LM End	20.27	Issue Type +	En	Location *	LS	
Category	Supplemental			GPS Latitude/Longitude		
				Start	End	
Item	DWR UCIP Field Study			37.193542 °	37.193542 °	
				-120.760300 °	-120.760300 °	
DWR ID						
Comment Code						
Inspector Comment						
FS_ID:39286						
DS_ID:24874						
EP_NO: N/A						
Repair Type: Non-Urgent						
Crossing Status: Found						
UCIP Comments: Dense vegetation limits the inspector's visibility to identify signs of pipe failure (leaks) along the waterward slope.						
Recommend removing vegetation along pipe alignment to conduct proper inspection of structure.						
FIELD_STRUCT_DESC: 18-inch steel sleeved into a 24-inch steel pipe through levee at an unknown depth.						
FS Date: 4/25/2014

View of landward side.

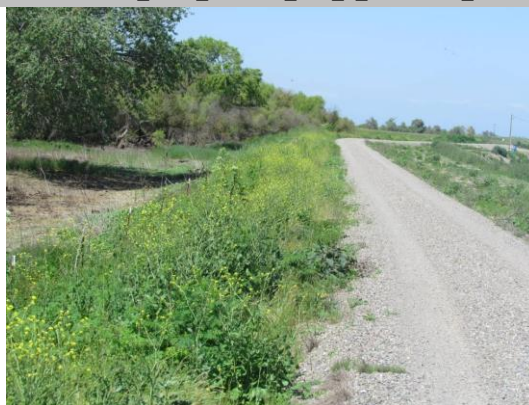
Photo 1 of 1 : SP\_2017\_NA0010\_118\_8\_20170424\_00281.jpg

LM Start	20.44	Rating **	U	Issue No.	8
LM End	22.46	Issue Type +	Ma	Location *	WS
Category	Earthen Levee			GPS Latitude/Longitude	
				Start	End
Item	Vegetation			37.191348 °	37.167498 °
				-120.761802 °	-120.750862 °
DWR ID	DWR_NA0010_01_f_2015_8				
Comment Code					
V2 : Remove the wild growth other than native grasses from the levee slopes.					
Inspector Comment					
Dense vegetation on waterward slope.

Looking downstream at dense veg on waterward slope.

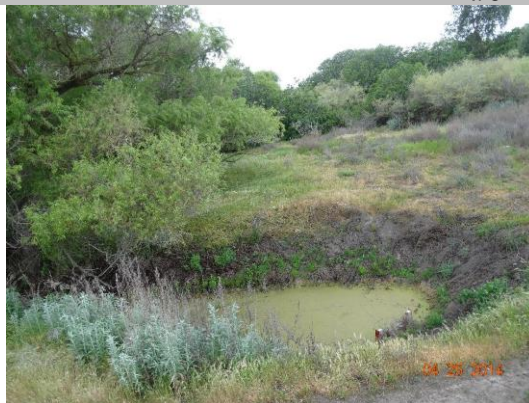
Photo 1 of 3 : UCIP\_SP\_2017\_39271\_66312.jpg

LM Start	21.40	Rating **	M	Issue No.	1266
LM End	21.40	Issue Type +	Ma	Location *	WS
Category	Supplemental			GPS Latitude/Longitude	
				Start	End
Item	DWR UCIP LMA Responsibility			37.179065 °	37.179065 °
				-120.761567 °	-120.761567 °
DWR ID					
Comment Code					
Inspector Comment					
FS_ID:39271 DS_ID:19603 EP_NO: N/A Repair Type: Non-Urgent Crossing Status: Found UCIP Comments: Crossing is non-functional--crossing buried on landward side. Need to contact owner to determine status of crossing. If crossing is no longer used need to coordinate with CVFPB for proper abandonment. FIELD_STRUCT_DESC: 36-inch CM pipe through the levee, 11.5 feet below the crown. Flap gate on the waterward end. Brass cap No. 40 BM on headwall on the landward side. (USACE-1967). This entry matches the Drainage or Irrigation Structure referenced in O&M manual (HLM 21.40). FS Date: 4/25/2014

View of waterward side.

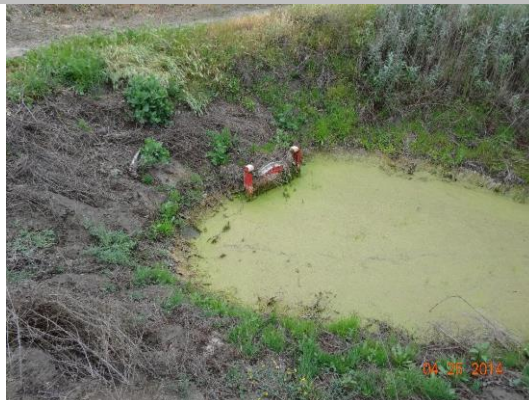
Photo 2 of 3 : UCIP\_SP\_2017\_39271\_66313.jpg

Flap gate half way submersed located on waterward side.

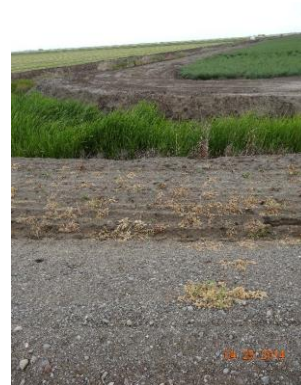
Photo 3 of 3 : UCIP\_SP\_2017\_39271\_66311.jpg

Item	DWR UCIP LMA Responsibility			37.179065 °		37.179065 °
				-120.761567 °		-120.761567 °
DWR ID						
Comment Code						
Inspector Comment						
FS_ID:39271 DS_ID:19603 EP_NO: N/A Repair Type: Non-Urgent Crossing Status: Found UCIP Comments: Crossing is non-functional--crossing buried on landward side. Need to contact owner to determine status of crossing. If crossing is no longer used need to coordinate with CVFPB for proper abandonment. FIELD_STRUCT_DESC: 36-inch CM pipe through the levee, 11.5 feet below the crown. Flap gate on the waterward end. Brass cap No. 40 BM on headwall on the landward side. (USACE-1967). This entry matches the Drainage or Irrigation Structure referenced in O&M manual (HLM 21.40). FS Date: 4/25/2014

View of landward side.

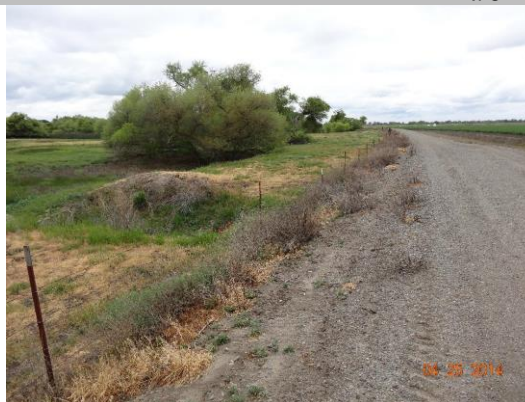
Photo 1 of 3 : UCIP\_SP\_2017\_39272\_65697.jpg

LM Start	21.75	Rating **	M	Issue No.	1267
LM End	21.75	Issue Type +	Ma	Location *	WS
Category	Supplemental			GPS Latitude/Longitude	
				Start	End
Item	DWR UCIP LMA Responsibility			37.176106 °	37.176106 °
				-120.756768 °	-120.756768 °
DWR ID					
Comment Code					
Inspector Comment					
FS_ID:39272 DS_ID:19604 EP_NO: N/A Repair Type: Non-Urgent Crossing Status: Found UCIP Comments: Non-functional crossing-landward side is buried. Need to contact owner to determine status of crossing. If crossing is no longer used need to coordinate with CVFPB for proper abandonment. FIELD_STRUCT_DESC: 24-inch CM pipe through the levee, 9.0 feet below the crown. Flap gate on the waterward end. Brass cap No. 40 BM on headwall on the landward side. (USACE-1967). This entry matches the Drainage or Irrigation Structure referenced in O&M manual (HLM 21.76). FS Date: 4/25/2014

View of waterward side.

Item	DWR UCIP LMA Responsibility			37.176106 °		37.176106 °
				-120.756768 °		-120.756768 °
DWR ID						
Comment Code						
Inspector Comment						
FS_ID:39272						
DS_ID:19604						
EP_NO: N/A						
Repair Type: Non-Urgent						
Crossing Status: Found						
UCIP Comments: Non-functional crossing-landward side is buried.						
Need to contact owner to determine status of crossing. If crossing is no longer used need to coordinate with CVFPB for proper abandonment.						
FIELD_STRUCT_DESC: 24-inch CM pipe through the levee, 9.0 feet below the crown. Flap gate on the waterward end. Brass cap No. 40 BM on headwall on the landward side. (USACE-1967). This entry matches the Drainage or Irrigation Structure referenced in O&M manual (HLM 21.76).						
FS Date: 4/25/2014

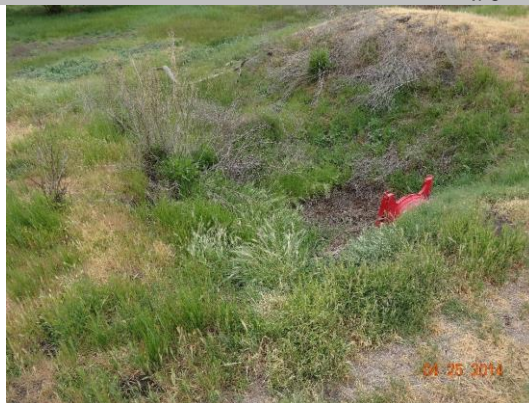
Photo 2 of 3 : UCIP\_SP\_2017\_39272\_65695.jpg

Flap gate visible on waterward side.

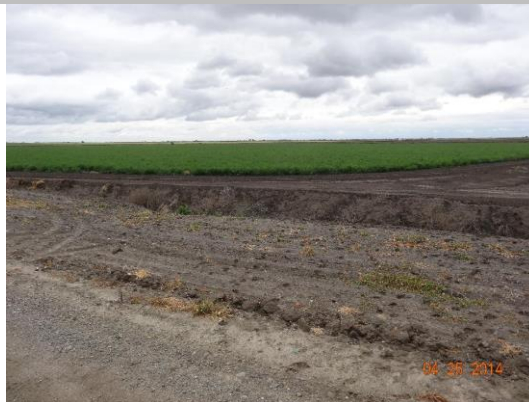
Photo 3 of 3 : UCIP\_SP\_2017\_39272\_65696.jpg

View of landward side.

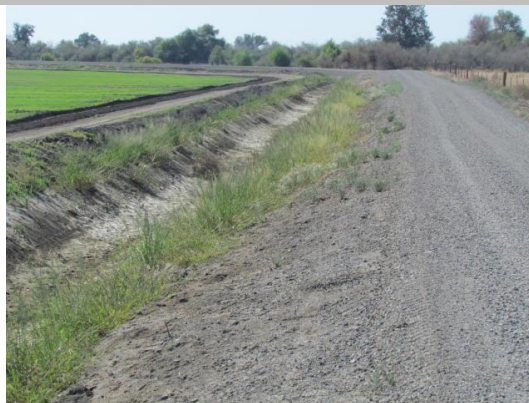
Photo 1 of 3 : SP\_2017\_NA0010\_118\_22\_20170417\_00015.jpg

LM Start	<b>22.06</b>	Rating **	U	Issue No.	<b>22 (cont)</b>
LM End	<b>22.51</b>	Issue Type +	En	Location *	LS

Looking downstream at irrigation ditch at LM 22.06

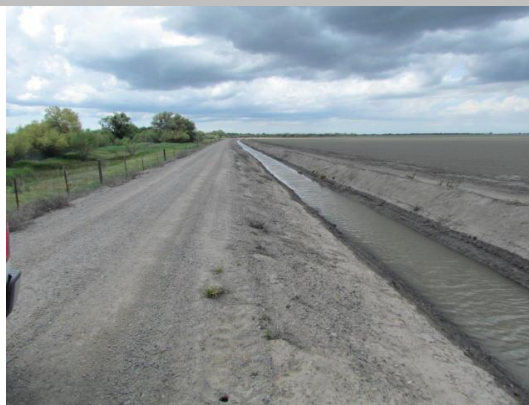
Photo 2 of 3 : SP\_2017\_NA0010\_118\_22\_20170417\_00016.jpg

Looking downstream at irrigation ditch at landside toe.

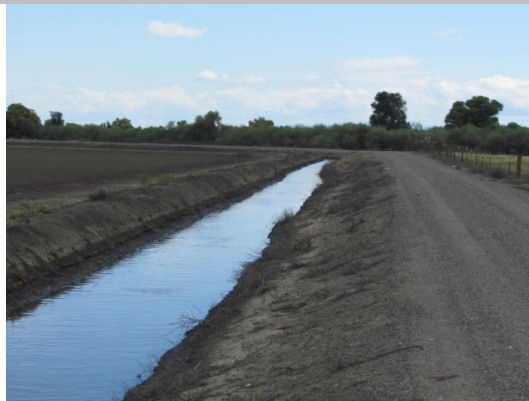
Photo 3 of 3 : SP\_2017\_NA0010\_118\_22\_20170417\_00017.jpg

Looking upstream at irrigation at landside toe.

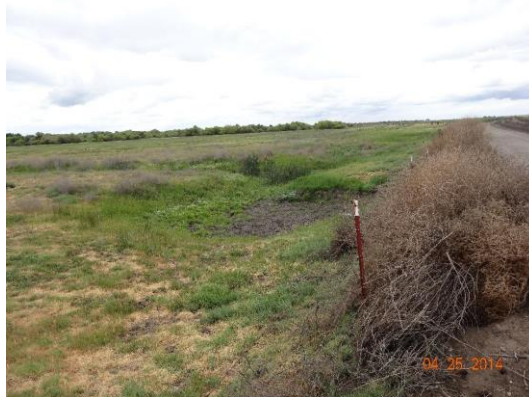
Photo 1 of 3 : UCIP\_SP\_2017\_39273\_65709.jpg

Comment Code					
Inspector Comment					
FS_ID:39273 DS_ID:19605 EP_NO: N/A Repair Type: Non-Urgent Crossing Status: Found UCIP Comments: Non-functional crossing--landward side is buried. Need to contact owner to determine status. If crossing is no longer used need to coordinate with CVFPB for proper abandonment. FIELD_STRUCT_DESC: 24-inch CM pipe through the levee, 9.0 feet below the crown. Flap gate on the waterward end. Wooden head- boards on the landward end of pipe. Brass cap No. 31 BM on headwall on the landward side. (USACE-1967). This entry matches the Drainage or Irrigation Structure referenced in O&M manual (HLM 22.13). FS Date: 4/25/2014

View of waterward side.

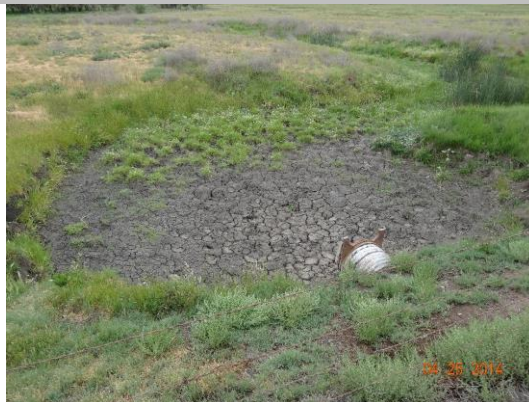
Photo 2 of 3 : UCIP\_SP\_2017\_39273\_65707.jpg

Flap gate visible on waterward side.

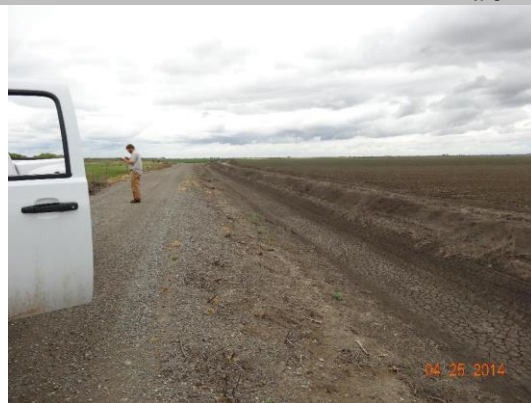
Photo 3 of 3 : UCIP\_SP\_2017\_39273\_65708.jpg

Item	DWR UCIP LMA Responsibility			37.171181 °	37.171181 °	
				-120.754526 °	-120.754526 °	
DWR ID						
Comment Code						
Inspector Comment						
FS_ID:39273 DS_ID:19605 EP_NO: N/A Repair Type: Non-Urgent Crossing Status: Found UCIP Comments: Non-functional crossing--landward side is buried. Need to contact owner to determine status. If crossing is no longer used need to coordinate with CVFPB for proper abandonment. FIELD_STRUCT_DESC: 24-inch CM pipe through the levee, 9.0 feet below the crown. Flap gate on the waterward end. Wooden head- boards on the landward end of pipe. Brass cap No. 31 BM on headwall on the landward side. (USACE-1967). This entry matches the Drainage or Irrigation Structure referenced in O&M manual (HLM 22.13). FS Date: 4/25/2014

View of landward side.

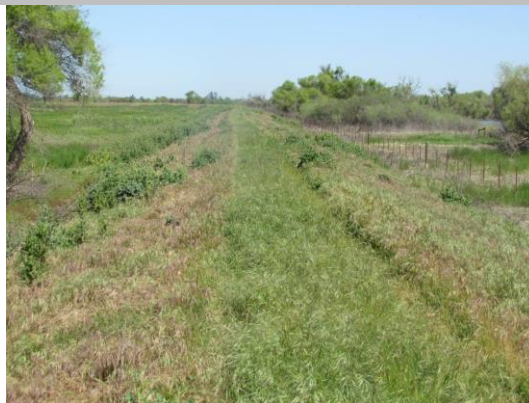
Photo 1 of 1 : SP\_2017\_NA0010\_119\_23\_20170424\_00071.jpg

LM Start	0.00	Rating **	M	Issue No.	23
LM End	0.69	Issue Type +	Ma	Location *	CR
Category	Earthen Levee			GPS Latitude/Longitude	
				Start	End
Item	Crown Surface / Depressions / Rutting			37.296318 °	37.287788 °
				-120.880600 °	-120.874720 °
DWR ID	DWR_NA0010_02A_s_2017_23				
Comment Code					
C3 : Add appropriate gravel or road base. Grade and compact.					
Inspector Comment					
Levee crown is over grown.

Looking downstream at overgrown levee crown.

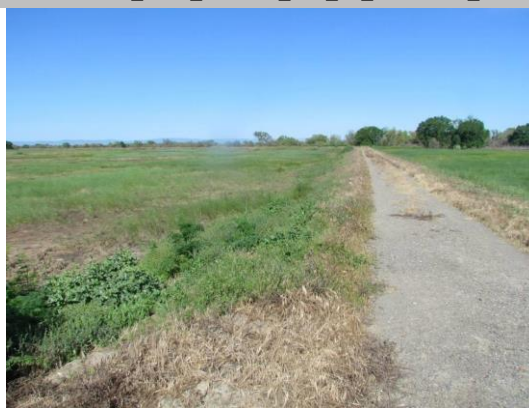
Photo 1 of 1 : SP\_2017\_NA0010\_119\_27\_20170424\_00072.jpg

LM Start	0.00	Rating **	M	Issue No.	27
LM End	7.86	Issue Type +	Ma	Location *	LS
Category	Earthen Levee			GPS Latitude/Longitude	
				Start	End
Item	Vegetation			37.296305 °	37.231303 °
				-120.880567 °	-120.811898 °
DWR ID	DWR_NA0010_02A_f _ 2015_27				
Comment Code					
V1 : Control annual grass and weeds on the levee slopes and easements.					
Inspector Comment

Looking typical view of landward slope.

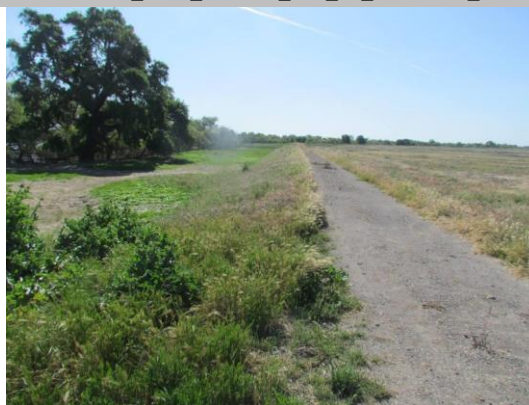
Photo 1 of 1 : SP\_2017\_NA0010\_119\_28\_20170424\_00073.jpg

LM Start	0.00	Rating **	M	Issue No.	28
LM End	7.86	Issue Type +	Ma	Location *	WS
Category	Earthen Levee			GPS Latitude/Longitude	
				Start	End
Item	Vegetation			37.296305 °	37.231303 °
				-120.880567 °	-120.811898 °
DWR ID	DWR_NA0010_02A_f_2015_28				
Comment Code					
V1 : Control annual grass and weeds on the levee slopes and easements.					
Inspector Comment

Looking at typical view of waterward slope.

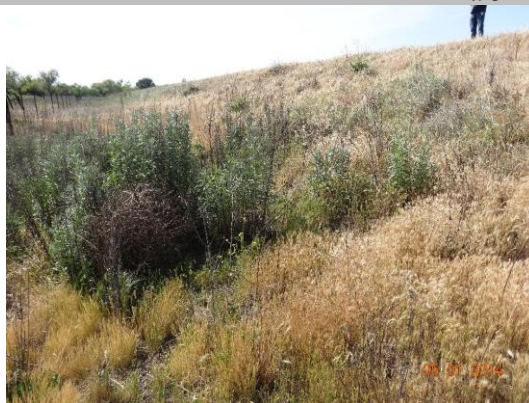
Photo 1 of 3 : UCIP\_SP\_2017\_36503\_66102.jpg

LM Start	0.23	Rating **	M	Issue No.	29
LM End	0.23	Issue Type +	Ma	Location *	WS
Category	Supplemental			GPS Latitude/Longitude	
				Start	End
Item	DWR UCIP LMA Responsibility			37.293440 °	37.293440 °
				-120.878978 °	-120.878978 °
DWR ID					
Comment Code					
Inspector Comment					
FS_ID:36503 DS_ID:19652 EP_NO: N/A Repair Type: Non-Urgent Crossing Status: Found UCIP Comments: Dense vegetation limits the inspector's visibility to identify signs of pipe failure (leaks) along the slope. Recommend removing vegetation along pipe alignment to conduct proper inspection of structure. FIELD_STRUCT_DESC: 24-inch CM pipe through the levee, 11.0 feet below the crown. Flap gate on the waterward end. Brass cap No. 139 BM on headwall on the landward side. (USACE-1967). This entry matches the Drainage or Irrigation Structure referenced in O&M manual (HLM 0.24). FS Date: 5/1/2014

View of waterward side.

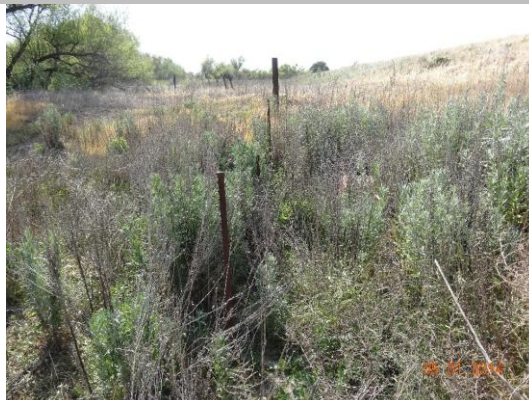
Photo 2 of 3 : UCIP\_SP\_2017\_36503\_66101.jpg

Fence along waterward side. No headwall was found on waterward side.
