**Flood Control Project Maintenance  
Levee Inspections**  
**LMA District Cover Sheet**  
**Spring 2017 Levee Inspection Results**

**Lower San Joaquin Levee District**

Waterway			Bank	Unit Miles
Unit No. 01 San Joaquin River			Right	22.52
	Spring (March - May)	Summer (June - August)	(September - November) Fall	Winter (December - February)
Unit Maintenance Rating (Fall Only)				
Date of Inspection	4/17/2017 - 4/20/2017			
DWR Inspector	Richard Willoughby			
Accompanied By

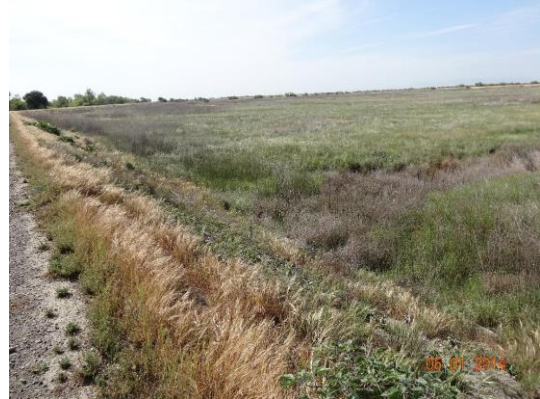
Photo 3 of 3 : UCIP\_SP\_2017\_36503\_66100.jpg

Comment Code						
Inspector Comment						
FS_ID:36503						
DS_ID:19652						
EP_NO: N/A						
Repair Type: Non-Urgent						
Crossing Status: Found						
UCIP Comments: Dense vegetation limits the inspector's visibility to identify signs of pipe failure (leaks) along the slope. Recommend removing vegetation along pipe alignment to conduct proper inspection of structure.						
FIELD_STRUCT_DESC: 24-inch CM pipe through the levee, 11.0 feet below the crown. Flap gate on the waterward end. Brass cap No. 139 BM on headwall on the landward side. (USACE-1967). This entry matches the Drainage or Irrigation Structure referenced in O&M manual (HLM 0.24).						
FS Date: 5/1/2014

View of landward side.

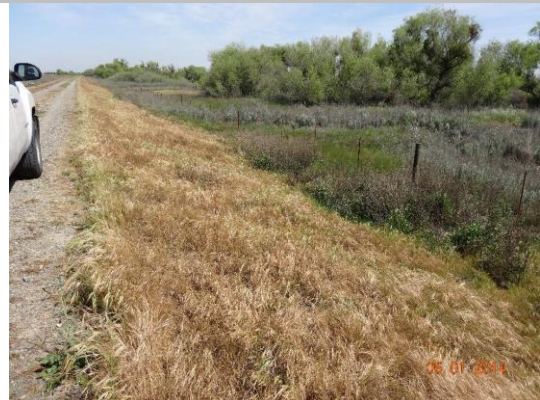
Photo 1 of 3 : UCIP\_SP\_2017\_36504\_66106.jpg

LM Start	0.66	Rating **	M	Issue No.	30
LM End	0.66	Issue Type +	Ma	Location *	WS
Category	Supplemental			GPS Latitude/Longitude	
				Start	End
Item	DWR UCIP LMA Responsibility			37.288087 °	37.288087 °
				-120.874919 °	-120.874919 °
DWR ID					
Comment Code					
Inspector Comment					
FS_ID:36504 DS_ID:19653 EP_NO: N/A Repair Type: Non-Urgent Crossing Status: Found UCIP Comments: Dense vegetation limits the inspector's visibility to identify signs of pipe failure (leaks) along the slope. Recommend removing vegetation along pipe alignment to conduct proper inspection of structure. FIELD_STRUCT_DESC: 24-inch CM pipe through the levee, 14.8 feet below the crown. Flap gate on the waterward end. Brass cap No. 138 BM on headwall on the landward side. (USACE-1967). This entry matches the Drainage or Irrigation Structure referenced in O&M manual (HLM 0.67). FS Date: 5/1/2014

View of waterward side.

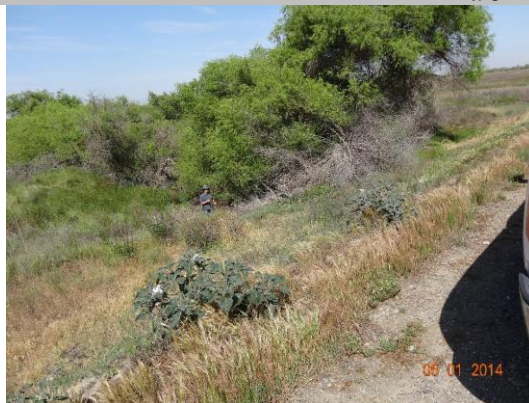
Photo 2 of 3 : UCIP\_SP\_2017\_36504\_66105.jpg

Comment Code						
Inspector Comment						
FS_ID:36504 DS_ID:19653 EP_NO: N/A Repair Type: Non-Urgent Crossing Status: Found UCIP Comments: Dense vegetation limits the inspector's visibility to identify signs of pipe failure (leaks) along the slope. Recommend removing vegetation along pipe alignment to conduct proper inspection of structure. FIELD_STRUCT_DESC: 24-inch CM pipe through the levee, 14.8 feet below the crown. Flap gate on the waterward end. Brass cap No. 138 BM on headwall on the landward side. (USACE-1967). This entry matches the Drainage or Irrigation Structure referenced in O&M manual (HLM 0.67). FS Date: 5/1/2014

View of landward side.

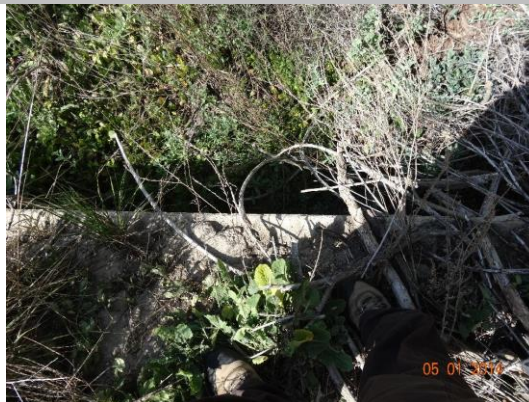
Photo 3 of 3 : UCIP\_SP\_2017\_36504\_66104.jpg

Concrete headwall found on landward side.

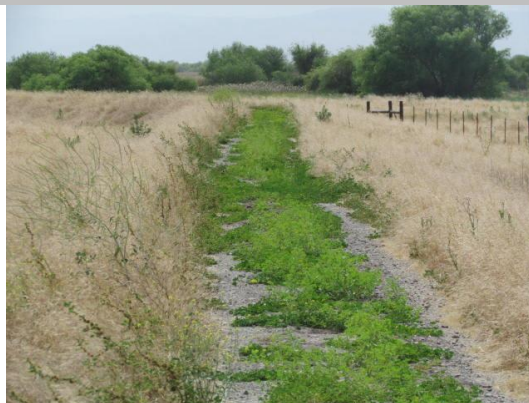
Photo 1 of 1 : SP\_2017\_NA0010\_119\_24\_20170417\_00010.jpg

LM Start	0.69	Rating **	M	Issue No.	24
LM End	7.83	Issue Type +	Ma	Location *	CR
Category	Earthen Levee			GPS Latitude/Longitude	
				Start	End
Item	Crown Surface / Depressions / Rutting			37.287788 °	37.231732 °
				-120.874720 °	-120.812347 °
DWR ID	DWR_NA0010_02A_s_2016_24				
Comment Code					
C2 : Repair depressions or ruts in the crown or slope.					
Inspector Comment					
Regrade levee rutting and pot holes.

Looking northeast at veg on levee crown.

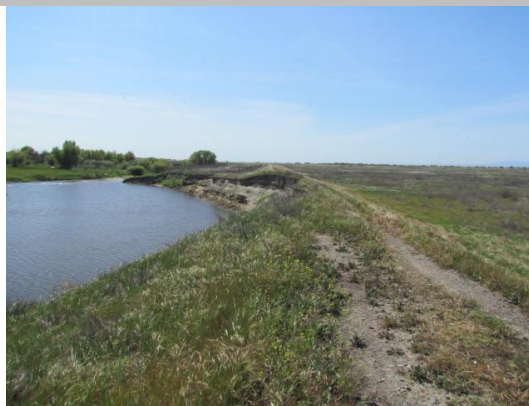
Photo 1 of 4 : SP\_2017\_NA0010\_119\_5\_20170417\_00007.jpg

LM Start	0.75	Rating **	U	Issue No.	5
LM End	0.75	Issue Type +	Ma	Location *	WS
Category	Earthen Levee			GPS Latitude/Longitude	
				Start	End
Item	Erosion / Bank Caving			37.286877 °	37.286877 °
				-120.874222 °	-120.874222 °
DWR ID	DWR_NA0010_02A_s_2012_5				
Comment Code					
E2 : Schedule repair of erosion site prior to the next inspection.					
Inspector Comment					
A field investigation report in on file. For more information and pictures see field investigation report #4301.

Looking south at large erosion on waterside slope. (Spring 2012)

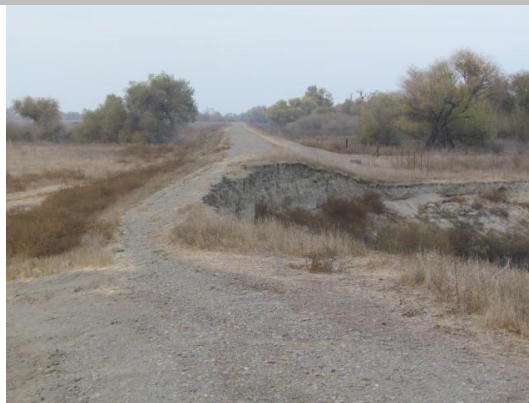
Photo 2 of 4 : SP\_2017\_NA0010\_119\_5\_20170417\_00006.jpg

Looking north at large erosion on waterward slope. (Fall 2013)

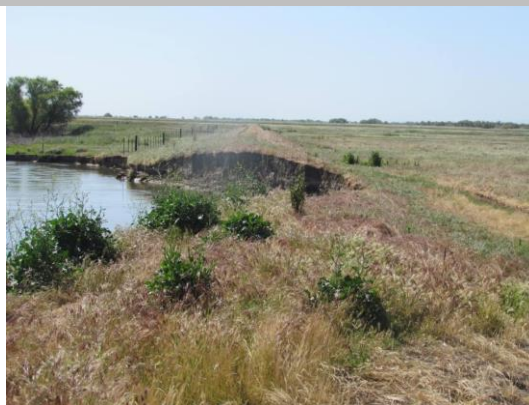
Photo 4 of 4 : SP\_2017\_NA0010\_119\_5\_20170424\_00075.jpg

Looking upstream at erosion fall 2017.

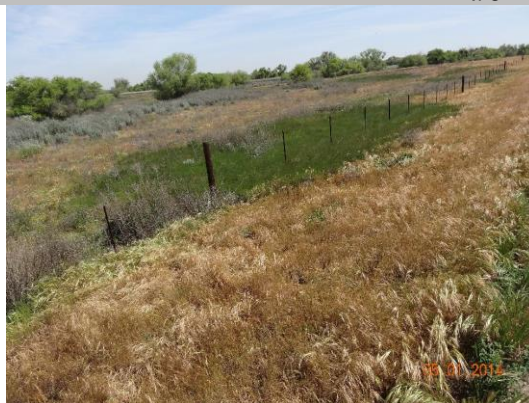
Photo 1 of 3 : UCIP\_SP\_2017\_39363\_66113.jpg

Comment Code					
Inspector Comment					
FS_ID:39363 DS_ID:19654 EP_NO: N/A Repair Type: Non-Urgent Crossing Status: Found UCIP Comments: Dense vegetation limits the inspector's visibility to identify signs of pipe failure (leaks) along the slope. Recommend removing vegetation along pipe alignment to conduct proper inspection of structure. Sediment buildup in pipe recommend clearing. FIELD_STRUCT_DESC: 24-inch CM pipe through the levee, 8.6 feet below the crown. Flap gate on the waterward end. Brass cap No. 137 BM on headwall on the landward side. (USACE-1967). This entry matches the Drainage or Irrigation Structure referenced in O&M manual (HLM 1.02). FS Date: 5/1/2014

View of waterward side.

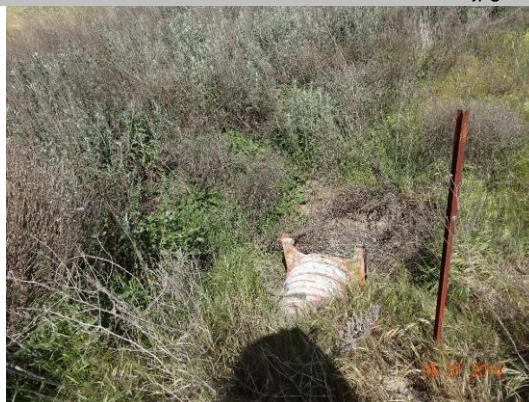
Photo 2 of 3 : UCIP\_SP\_2017\_39363\_66112.jpg

Pipe visible on waterward side.

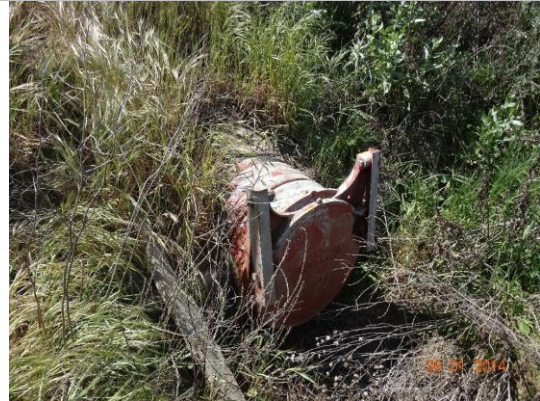
Photo 3 of 3 : UCIP\_SP\_2017\_39363\_66111.jpg

Comment Code						
Inspector Comment						
FS_ID:39363						
DS_ID:19654						
EP_NO: N/A						
Repair Type: Non-Urgent						
Crossing Status: Found						
UCIP Comments: Dense vegetation limits the inspector's visibility to identify signs of pipe failure (leaks) along the slope. Recommend removing vegetation along pipe alignment to conduct proper inspection of structure. Sediment buildup in pipe recommend clearing.						
FIELD_STRUCT_DESC: 24-inch CM pipe through the levee, 8.6 feet below the crown. Flap gate on the waterward end. Brass cap No. 137 BM on headwall on the landward side. (USACE-1967). This entry matches the Drainage or Irrigation Structure referenced in O&M manual (HLM 1.02).						
FS Date: 5/1/2014

Flap gate visible on waterward side.

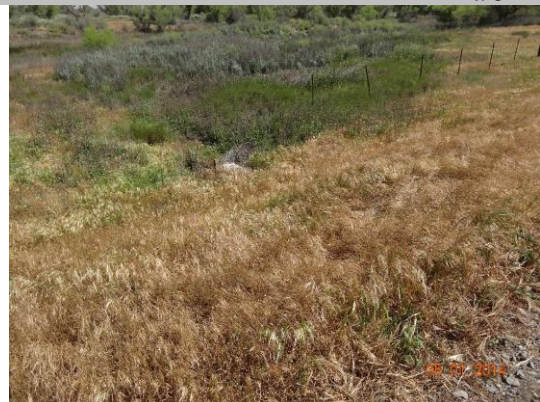
Photo 1 of 3 : UCIP\_SP\_2017\_36506\_66114.jpg

LM Start	1.21	Rating **	M	Issue No.	32
LM End	1.21	Issue Type +	Ma	Location *	WS
Category	Supplemental			GPS Latitude/Longitude	
				Start	End
Item	DWR UCIP LMA Responsibility			37.286118 °	37.286118 °
				-120.868167 °	-120.868167 °
DWR ID					
Comment Code					
Inspector Comment					
FS_ID:36506 DS_ID:19655 EP_NO: N/A Repair Type: Non-Urgent Crossing Status: Found UCIP Comments: Dense vegetation limits the inspector's visibility to identify signs of pipe failure (leaks) along the slope. Recommend removing vegetation along pipe alignment to conduct proper inspection of structure. FIELD_STRUCT_DESC: 24-inch CM pipe through the levee, 8.6 feet below the crown. Flap gate on the waterward end. Brass cap No. 136 BM on headwall on the landward side. (USACE-1967). This entry matches the Drainage or Irrigation Structure referenced in O&M manual (HLM 1.22). FS Date: 5/1/2014

Overview of waterward side.

Comment Code						
Inspector Comment						
FS_ID:36506 DS_ID:19655 EP_NO: N/A Repair Type: Non-Urgent Crossing Status: Found UCIP Comments: Dense vegetation limits the inspector's visibility to identify signs of pipe failure (leaks) along the slope. Recommend removing vegetation along pipe alignment to conduct proper inspection of structure. FIELD_STRUCT_DESC: 24-inch CM pipe through the levee, 8.6 feet below the crown. Flap gate on the waterward end. Brass cap No. 136 BM on headwall on the landward side. (USACE-1967). This entry matches the Drainage or Irrigation Structure referenced in O&M manual (HLM 1.22). FS Date: 5/1/2014

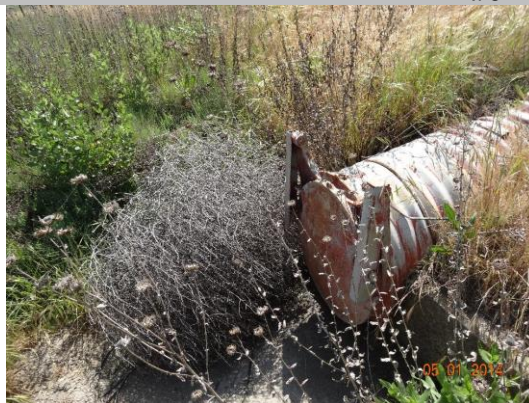
Photo 2 of 3 : UCIP\_SP\_2017\_36506\_66117.jpg

Flap gate visible on waterward side.

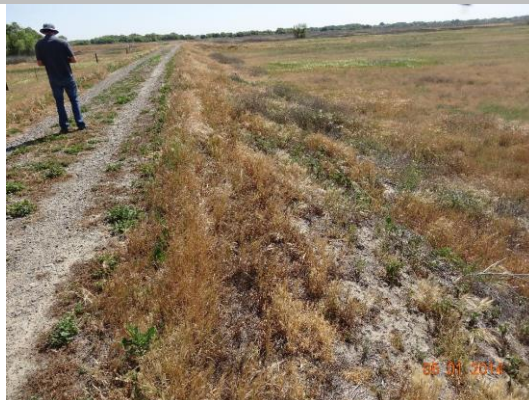
Photo 3 of 3 : UCIP\_SP\_2017\_36506\_66116.jpg

View of landward side.

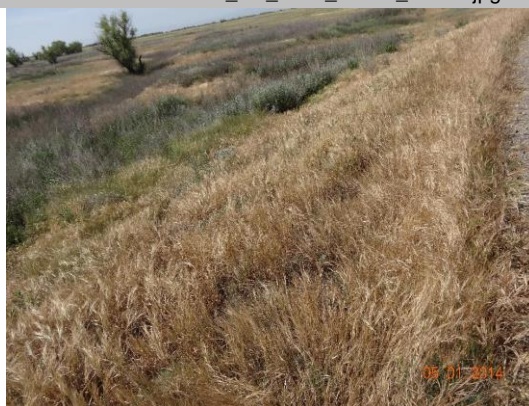
Photo 1 of 3 : UCIP\_SP\_2017\_36507\_66120.jpg

LM Start	1.33	Rating **	M	Issue No.	33
LM End	1.33	Issue Type +	Ma	Location *	WS
Category	Supplemental			GPS Latitude/Longitude	
				Start	End
Item	DWR UCIP LMA Responsibility			37.286463 °	37.286463 °
				-120.865997 °	-120.865997 °
DWR ID					
Comment Code					
Inspector Comment					
FS_ID:36507 DS_ID:19656 EP_NO: N/A Repair Type: Non-Urgent Crossing Status: Found UCIP Comments: Dense vegetation limits the inspector's visibility to identify signs of pipe failure (leaks) along the slope. Recommend removing vegetation along pipe alignment to conduct proper inspection of structure. FIELD_STRUCT_DESC: 36-inch CM pipe through the levee, 14.6 feet below the crown. Flap gate on the waterward end. Brass cap No. 135 BM on headwall on the landward side. (USACE-1967). This entry matches the Drainage or Irrigation Structure referenced in O&M manual (HLM 1.34). FS Date: 5/1/2014

View of landward side.

Comment Code						
Inspector Comment						
FS_ID:36507 DS_ID:19656 EP_NO: N/A Repair Type: Non-Urgent Crossing Status: Found UCIP Comments: Dense vegetation limits the inspector's visibility to identify signs of pipe failure (leaks) along the slope. Recommend removing vegetation along pipe alignment to conduct proper inspection of structure. FIELD_STRUCT_DESC: 36-inch CM pipe through the levee, 14.6 feet below the crown. Flap gate on the waterward end. Brass cap No. 135 BM on headwall on the landward side. (USACE-1967). This entry matches the Drainage or Irrigation Structure referenced in O&M manual (HLM 1.34). FS Date: 5/1/2014

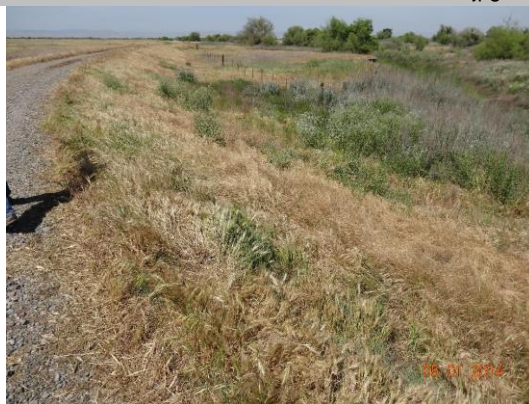
Photo 2 of 3 : UCIP\_SP\_2017\_36507\_66119.jpg

View of waterward side.

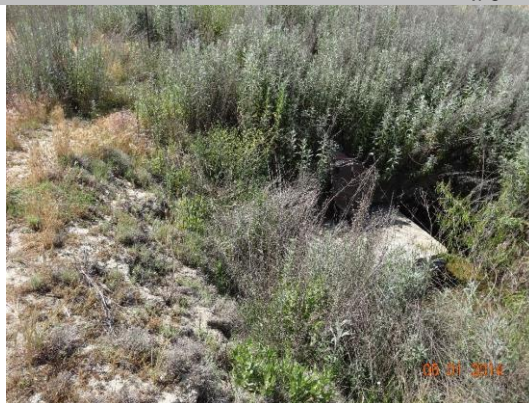
Photo 3 of 3 : UCIP\_SP\_2017\_36507\_66118.jpg

Flap gate and concrete apron visible on waterward side.

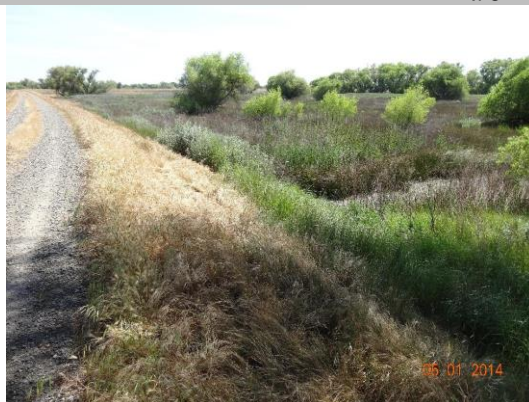
Photo 1 of 3 : UCIP\_SP\_2017\_36508\_66124.jpg

LM Start	1.61	Rating **	M	Issue No.	34
LM End	1.61	Issue Type +	Ma	Location *	WS
Category	Supplemental			GPS Latitude/Longitude	
				Start	End
Item	DWR UCIP LMA Responsibility			37.288599 °	37.288599 °
				-120.862007 °	-120.862007 °
DWR ID					
Comment Code					
Inspector Comment					
FS_ID:36508 DS_ID:19657 EP_NO: N/A Repair Type: Non-Urgent Crossing Status: Found UCIP Comments: Dense vegetation limits the inspector's visibility to identify signs of pipe failure (leaks) along the slope. Recommend removing vegetation along pipe alignment to conduct proper inspection of structure. FIELD_STRUCT_DESC: 24-inch CM pipe through the levee, 10.2 feet below the crown. Flap gate on the waterward end. Brass cap No. 135 BM on headwall on the landward side. (USACE-1967). This entry matches the Drainage or Irrigation Structure referenced in O&M manual (HLM 1.62). FS Date: 5/1/2014

Overview of landward side.

Comment Code						
Inspector Comment						
FS_ID:36508 DS_ID:19657 EP_NO: N/A Repair Type: Non-Urgent Crossing Status: Found UCIP Comments: Dense vegetation limits the inspector's visibility to identify signs of pipe failure (leaks) along the slope. Recommend removing vegetation along pipe alignment to conduct proper inspection of structure. FIELD_STRUCT_DESC: 24-inch CM pipe through the levee, 10.2 feet below the crown. Flap gate on the waterward end. Brass cap No. 135 BM on headwall on the landward side. (USACE-1967). This entry matches the Drainage or Irrigation Structure referenced in O&M manual (HLM 1.62). FS Date: 5/1/2014

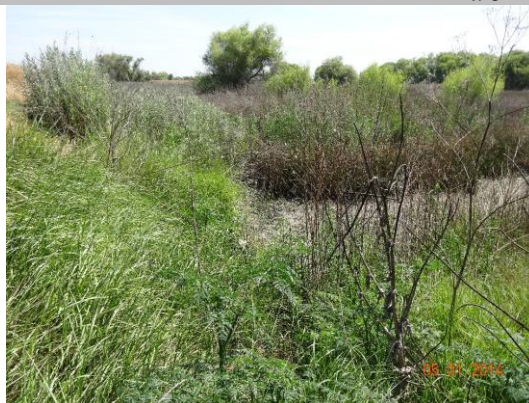
Photo 2 of 3 : UCIP\_SP\_2017\_36508\_66123.jpg

Dense vegetation along levee slope and toe.

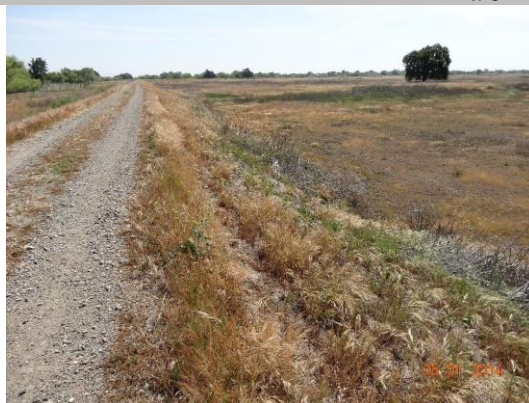
Photo 1 of 3 : UCIP\_SP\_2017\_36509\_66129.jpg

LM Start	1.85	Rating **	M	Issue No.	35
LM End	1.85	Issue Type +	Ma	Location *	WS
Category	Supplemental			GPS Latitude/Longitude	
				Start	End
Item	DWR UCIP LMA Responsibility			37.290836 °	37.290836 °
				-120.858882 °	-120.858882 °
DWR ID					
Comment Code					
Inspector Comment					
FS_ID:36509 DS_ID:19658 EP_NO: N/A Repair Type: Non-Urgent Crossing Status: Found UCIP Comments: Dense vegetation limits the inspector's visibility to identify signs of pipe failure (leaks) along the slope. Recommend removing vegetation along pipe alignment to conduct proper inspection of structure. FIELD_STRUCT_DESC: 24-inch CM pipe through the levee, 10.7 feet below the crown. Flap gate on the waterward end. Brass cap No. 135 BM on headwall on the landward side. (USACE-1967). This entry matches the Drainage or Irrigation Structure referenced in O&M manual (HLM 1.86). FS Date: 5/1/2014

View of landward side.

Comment Code						
Inspector Comment						
FS_ID:36509 DS_ID:19658 EP_NO: N/A Repair Type: Non-Urgent Crossing Status: Found UCIP Comments: Dense vegetation limits the inspector's visibility to identify signs of pipe failure (leaks) along the slope. Recommend removing vegetation along pipe alignment to conduct proper inspection of structure. FIELD_STRUCT_DESC: 24-inch CM pipe through the levee, 10.7 feet below the crown. Flap gate on the waterward end. Brass cap No. 135 BM on headwall on the landward side. (USACE-1967). This entry matches the Drainage or Irrigation Structure referenced in O&M manual (HLM 1.86). FS Date: 5/1/2014

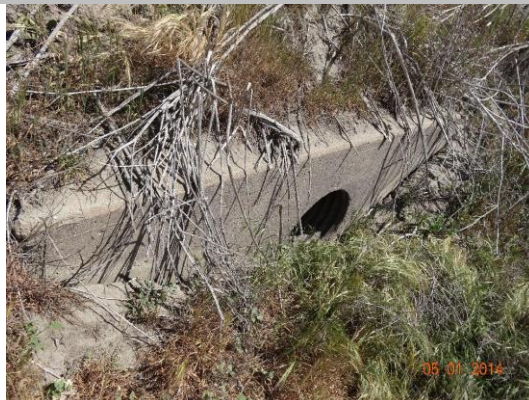
Photo 2 of 3 : UCIP\_SP\_2017\_36509\_66128.jpg

Concrete headwall visible on landward side.

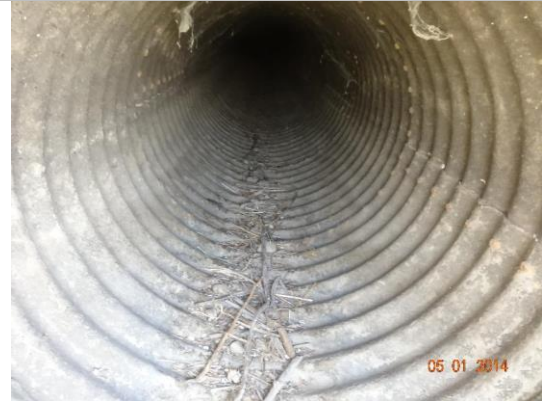
Photo 3 of 3 : UCIP\_SP\_2017\_36509\_66127.jpg

Inside view of pipe from landward side.

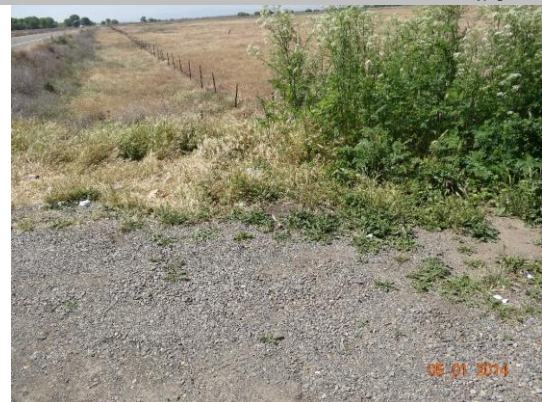
Photo 1 of 3 : UCIP\_SP\_2017\_36510\_66133.jpg

LM Start	2.28	Rating **	M	Issue No.	36
LM End	2.28	Issue Type +	Ma	Location *	WS
Category	Supplemental			GPS Latitude/Longitude	
				Start	End
Item	DWR UCIP LMA Responsibility			37.291686 °	37.291686 °
				-120.851475 °	-120.851475 °
DWR ID					
Comment Code					
Inspector Comment					
FS_ID:36510 DS_ID:19659 EP_NO: N/A Repair Type: Non-Urgent Crossing Status: Found UCIP Comments: Dense vegetation limits the inspector's visibility to identify signs of pipe failure (leaks) along the slope. Recommend removing vegetation along pipe alignment to conduct proper inspection of structure. FIELD_STRUCT_DESC: 24-inch CM pipe through the levee, 7.0 feet below the crown. Flap gate on the waterward end. Brass cap No. 135 BM on headwall on the landward side. (USACE-1967). This entry matches the Drainage or Irrigation Structure referenced in O&M manual (HLM 2.30). FS Date: 5/1/2014

View of landward side.

Comment Code						
Inspector Comment						
FS_ID:36510 DS_ID:19659 EP_NO: N/A Repair Type: Non-Urgent Crossing Status: Found UCIP Comments: Dense vegetation limits the inspector's visibility to identify signs of pipe failure (leaks) along the slope. Recommend removing vegetation along pipe alignment to conduct proper inspection of structure. FIELD_STRUCT_DESC: 24-inch CM pipe through the levee, 7.0 feet below the crown. Flap gate on the waterward end. Brass cap No. 135 BM on headwall on the landward side. (USACE-1967). This entry matches the Drainage or Irrigation Structure referenced in O&M manual (HLM 2.30). FS Date: 5/1/2014

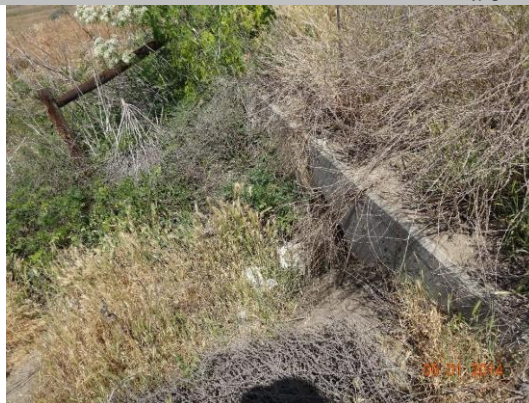
Photo 2 of 3 : UCIP\_SP\_2017\_36510\_66132.jpg

Concrete headwall visible on landward side.

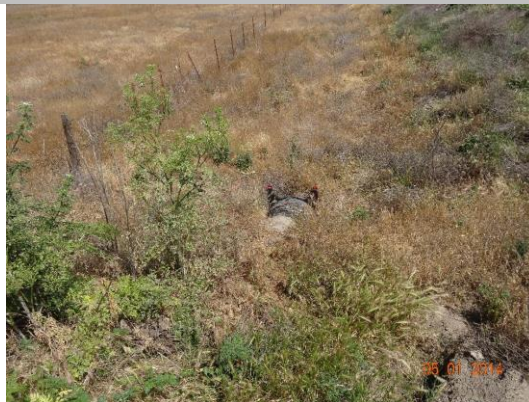
Photo 3 of 3 : UCIP\_SP\_2017\_36510\_66131.jpg

View of pipe through levee visible on waterward side.

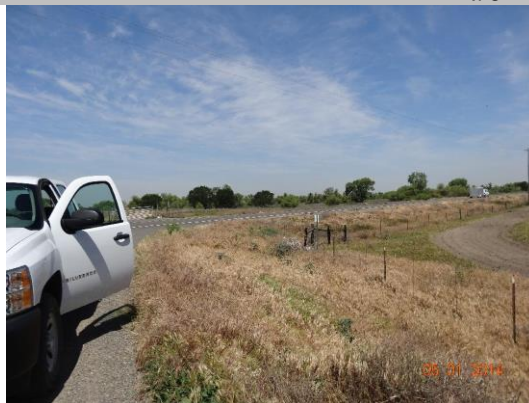
Photo 1 of 3 : UCIP\_SP\_2017\_36511\_66137.jpg

LM Start	2.30	Rating **	M	Issue No.	37
LM End	2.30	Issue Type +	Ma	Location *	WS
Category	Supplemental			GPS Latitude/Longitude	
				Start	End
Item	DWR UCIP LMA Responsibility			37.291532 °	37.291532 °
				-120.851203 °	-120.851203 °
DWR ID					
Comment Code					
Inspector Comment					
FS_ID:36511 DS_ID:19660 EP_NO: N/A Repair Type: Non-Urgent Crossing Status: Found UCIP Comments: Dense vegetation limits the inspector's visibility to identify signs of pipe failure (leaks) along the slope. Recommend removing vegetation along pipe alignment to conduct proper inspection of structure. FIELD_STRUCT_DESC: 24-inch CM pipe through the levee, 7.0 feet below the crown. Flap gate on the waterward end. Brass cap No. 135 BM on headwall on the landward side. (USACE-1967). This entry matches the Drainage or Irrigation Structure referenced in O&M manual (HLM 2.32). FS Date: 5/1/2014

View of waterward side.

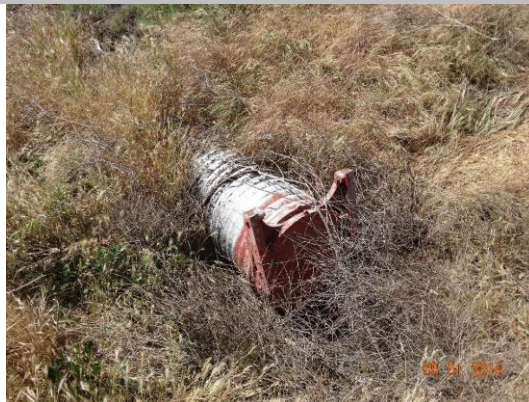
Photo 2 of 3 : UCIP\_SP\_2017\_36511\_66136.jpg

Flap gate visible on waterward side.

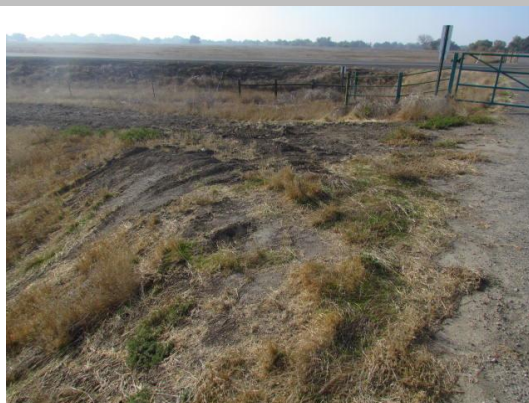
Photo 3 of 4 : SP\_2017\_NA0010\_119\_2\_20170417\_00003.jpg

Looking northwest at unauthorized ramp on waterward slope.

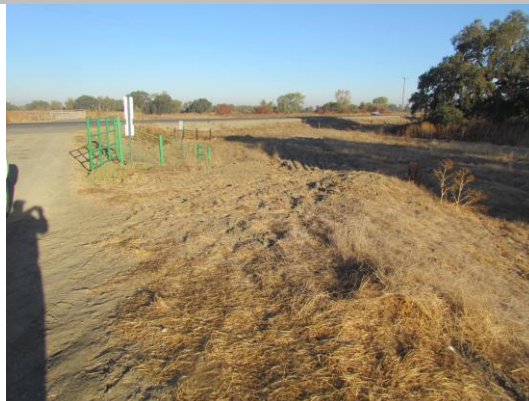
Photo 4 of 4 : SP\_2017\_NA0010\_119\_2\_20170417\_00004.jpg

Looking at ramp on landward slope. (Fall 2016)

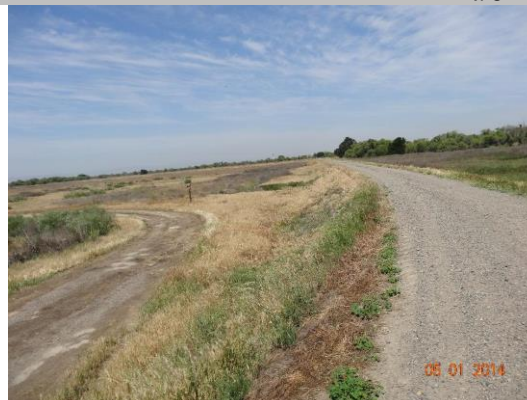
Photo 1 of 3 : UCIP\_SP\_2017\_36512\_66142.jpg

LM Start	2.58	Rating **	M	Issue No.	38
LM End	2.58	Issue Type +	Ma	Location *	LS
Category	Supplemental			GPS Latitude/Longitude	
				Start	End
Item	DWR UCIP LMA Responsibility			37.289487 °	37.289487 °
				-120.846941 °	-120.846941 °
DWR ID					
Comment Code					
Inspector Comment					
FS_ID:36512 DS_ID:19661 EP_NO: N/A Repair Type: Non-Urgent Crossing Status: Found UCIP Comments: Dense vegetation limits the inspector's visibility to identify signs of pipe failure (leaks) along the slope. Recommend removing vegetation along pipe alignment to conduct proper inspection of structure. FIELD_STRUCT_DESC: 24-inch CM pipe through the levee, 10.0 feet below the crown. Flap gate on the waterward end. Brass cap No. 130 BM on headwall on the landward side. (USACE-1967). This entry matches the Drainage or Irrigation Structure referenced in O&M manual (HLM 2.59). FS Date: 5/1/2014

View of landward side.

Comment Code						
Inspector Comment						
FS_ID:36512						
DS_ID:19661						
EP_NO: N/A						
Repair Type: Non-Urgent						
Crossing Status: Found						
UCIP Comments: Dense vegetation limits the inspector's visibility to identify signs of pipe failure (leaks) along the slope. Recommend removing vegetation along pipe alignment to conduct proper inspection of structure.						
FIELD_STRUCT_DESC: 24-inch CM pipe through the levee, 10.0 feet below the crown. Flap gate on the waterward end. Brass cap No. 130 BM on headwall on the landward side. (USACE-1967). This entry matches the Drainage or Irrigation Structure referenced in O&M manual (HLM 2.59).						
FS Date: 5/1/2014

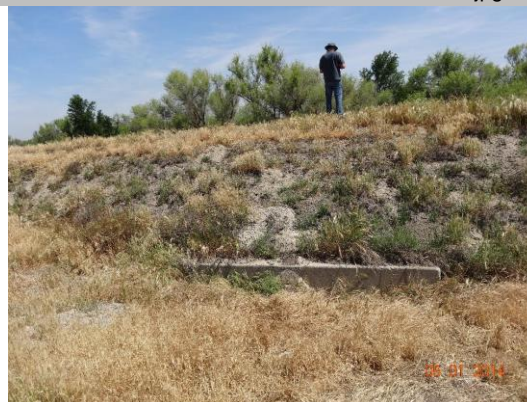
Photo 2 of 3 : UCIP\_SP\_2017\_36512\_66141.jpg

Concrete headwall visible on landward side.

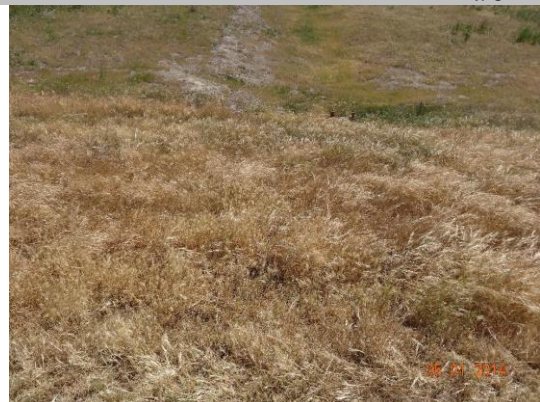
Photo 1 of 3 : UCIP\_SP\_2017\_36513\_66145.jpg

LM Start	2.95	Rating **	M	Issue No.	39
LM End	2.95	Issue Type +	Ma	Location *	LS
Category	Supplemental			GPS Latitude/Longitude	
				Start	End
Item	DWR UCIP LMA Responsibility			37.284326 °	37.284326 °
				-120.845157 °	-120.845157 °
DWR ID					
Comment Code					
Inspector Comment					
FS_ID:36513 DS_ID:19662 EP_NO: N/A Repair Type: Non-Urgent Crossing Status: Found UCIP Comments: Dense vegetation limits the inspector's visibility to identify signs of pipe failure (leaks) along the slope. Recommend removing vegetation along pipe alignment to conduct proper inspection of structure. FIELD_STRUCT_DESC: 24-inch CM pipe through the levee, 10.0 feet below the crown. Flap gate on the waterward end. Brass cap No. 130 BM on headwall on the landward side. (USACE-1967). This entry matches the Drainage or Irrigation Structure referenced in O&M manual (HLM 2.96). FS Date: 5/1/2014

View of waterward side.

Comment Code						
Inspector Comment						
FS_ID:36513 DS_ID:19662 EP_NO: N/A Repair Type: Non-Urgent Crossing Status: Found UCIP Comments: Dense vegetation limits the inspector's visibility to identify signs of pipe failure (leaks) along the slope. Recommend removing vegetation along pipe alignment to conduct proper inspection of structure. FIELD_STRUCT_DESC: 24-inch CM pipe through the levee, 10.0 feet below the crown. Flap gate on the waterward end. Brass cap No. 130 BM on headwall on the landward side. (USACE-1967). This entry matches the Drainage or Irrigation Structure referenced in O&M manual (HLM 2.96). FS Date: 5/1/2014

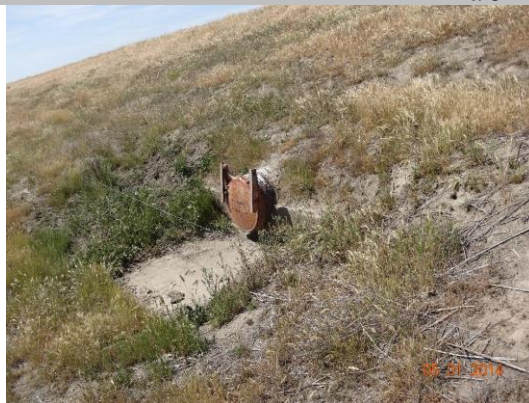
Photo 2 of 3 : UCIP\_SP\_2017\_36513\_66144.jpg

Flap gate visible on waterward side.

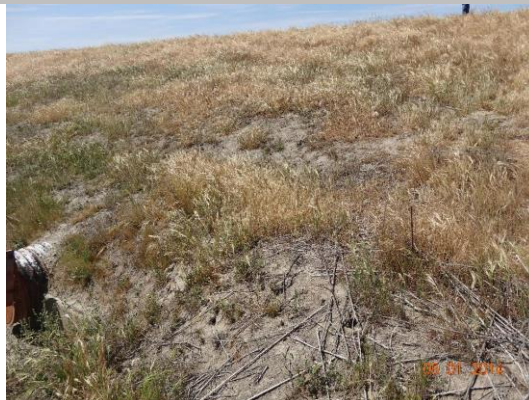
Photo 3 of 3 : UCIP\_SP\_2017\_36513\_66149.jpg

View of slope on waterward side.

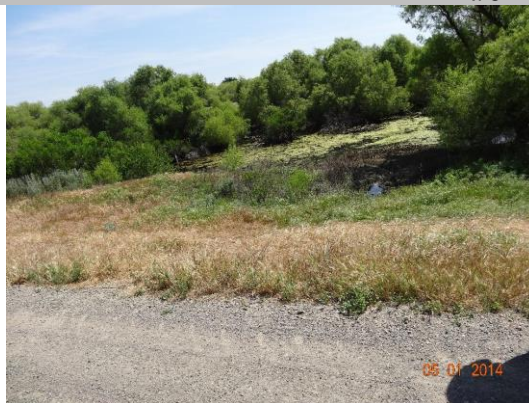
Photo 1 of 3 : UCIP\_SP\_2017\_36514\_66151.jpg

LM Start	3.28	Rating **	M	Issue No.	40
LM End	3.28	Issue Type +	Ma	Location *	LS
Category	Supplemental			GPS Latitude/Longitude	
				Start	End
Item	DWR UCIP LMA Responsibility			37.279656 °	37.279656 °
				-120.844795 °	-120.844795 °
DWR ID					
Comment Code					
Inspector Comment					
FS_ID:36514 DS_ID:19665 EP_NO: N/A Repair Type: Non-Urgent Crossing Status: Found UCIP Comments: Dense vegetation limits the inspector's visibility to identify signs of pipe failure (leaks) along the slope. Recommend removing vegetation along pipe alignment to conduct proper inspection of structure. FIELD_STRUCT_DESC: 24-inch CM pipe through the levee, 12.4 feet below the crown. Flap gate on the waterward end. Brass cap No. 130 BM on headwall on the landward side. (USACE-1967). This entry matches the Drainage or Irrigation Structure referenced in O&M manual (HLM 3.29). FS Date: 5/1/2014

View of waterward side.

Comment Code						
Inspector Comment						
FS_ID:36514 DS_ID:19665 EP_NO: N/A Repair Type: Non-Urgent Crossing Status: Found UCIP Comments: Dense vegetation limits the inspector's visibility to identify signs of pipe failure (leaks) along the slope. Recommend removing vegetation along pipe alignment to conduct proper inspection of structure. FIELD_STRUCT_DESC: 24-inch CM pipe through the levee, 12.4 feet below the crown. Flap gate on the waterward end. Brass cap No. 130 BM on headwall on the landward side. (USACE-1967). This entry matches the Drainage or Irrigation Structure referenced in O&M manual (HLM 3.29). FS Date: 5/1/2014

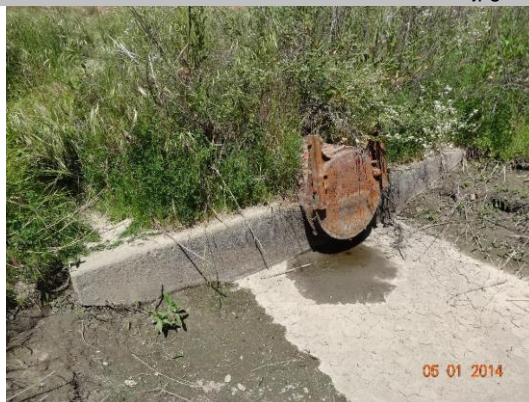
Photo 2 of 3 : UCIP\_SP\_2017\_36514\_66153.jpg

Flap gate visible on waterward side.

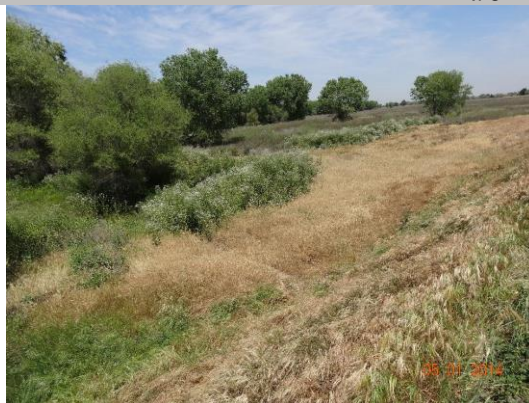
Photo 3 of 3 : UCIP\_SP\_2017\_36514\_66152.jpg

View of landward side.

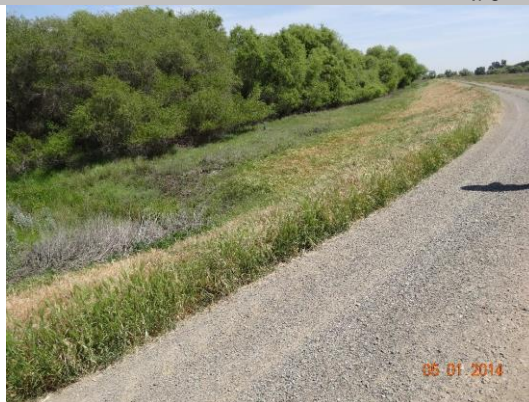
Photo 1 of 3 : UCIP\_SP\_2017\_36515\_66155.jpg

LM Start	3.61	Rating **	M	Issue No.	41
LM End	3.61	Issue Type +	Ma	Location *	LS
Category	Supplemental			GPS Latitude/Longitude	
				Start	End
Item	DWR UCIP LMA Responsibility			37.278203 °	37.278203 °
				-120.839884 °	-120.839884 °
DWR ID					
Comment Code					
Inspector Comment					
FS_ID:36515 DS_ID:19666 EP_NO: N/A Repair Type: Non-Urgent Crossing Status: Found UCIP Comments: Dense vegetation limits the inspector's visibility to identify signs of pipe failure (leaks) along the slope. Recommend removing vegetation along pipe alignment to conduct proper inspection of structure. FIELD_STRUCT_DESC: 24-inch CM pipe through the levee, 10.0 feet below the crown. Flap gate on the waterward end. Brass cap No. 130 BM on headwall on the landward side. (USACE-1967). This entry matches the Drainage or Irrigation Structure referenced in O&M manual (HLM 3.62). FS Date: 5/1/2014

View of waterward side.

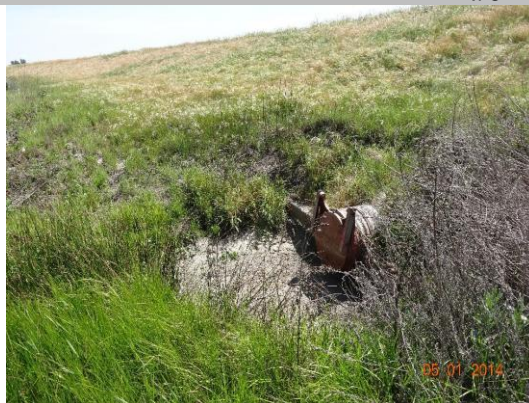
Photo 2 of 3 : UCIP\_SP\_2017\_36515\_66154.jpg

Comment Code						
Inspector Comment						
FS_ID:36515 DS_ID:19666 EP_NO: N/A Repair Type: Non-Urgent Crossing Status: Found UCIP Comments: Dense vegetation limits the inspector's visibility to identify signs of pipe failure (leaks) along the slope. Recommend removing vegetation along pipe alignment to conduct proper inspection of structure. FIELD_STRUCT_DESC: 24-inch CM pipe through the levee, 10.0 feet below the crown. Flap gate on the waterward end. Brass cap No. 130 BM on headwall on the landward side. (USACE-1967). This entry matches the Drainage or Irrigation Structure referenced in O&M manual (HLM 3.62). FS Date: 5/1/2014

Flap gate visible on waterward side.

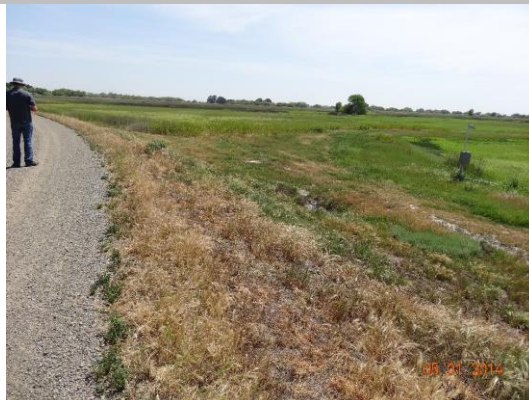
Photo 3 of 3 : UCIP\_SP\_2017\_36515\_66156.jpg

View of landward side.

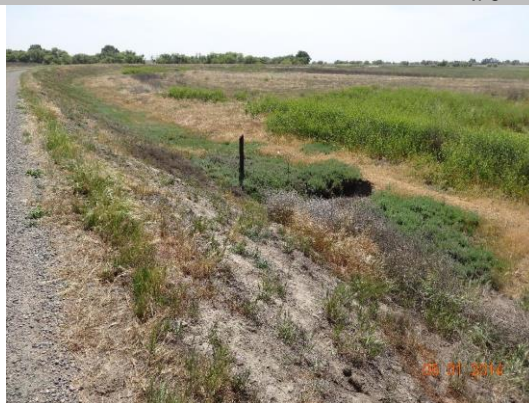
Photo 1 of 3 : UCIP\_SP\_2017\_39364\_66161.jpg

Comment Code					
Inspector Comment					
FS_ID:39364 DS_ID:19667 EP_NO: N/A Repair Type: Non-Urgent Crossing Status: Found UCIP Comments: Signs of erosion or sink hole present on landward toe--Need to contact owner. Dense vegetation limits the inspector's visibility to identify signs of pipe failure (leaks) along the slope. Recommend removing vegetation along pipe alignment to conduct proper inspection of structure. FIELD_STRUCT_DESC: 24-inch CM pipe through the levee, 8.6 feet below the crown. Flap gate on the waterward end. Brass cap No. 130 BM on headwall on the landward side. (USACE-1967). This entry matches the Drainage or Irrigation Structure referenced in O&M manual (HLM 3.95). FS Date: 5/1/2014

View of landward side.

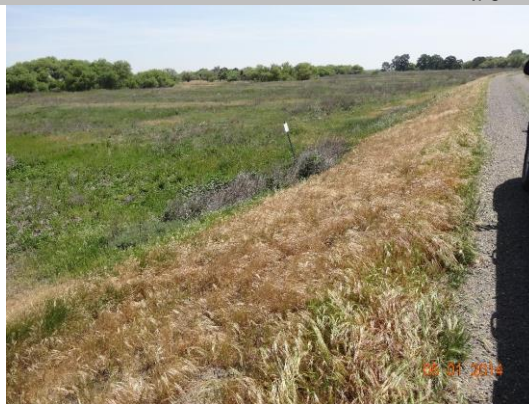
Photo 2 of 3 : UCIP\_SP\_2017\_39364\_66160.jpg

View of waterward side.

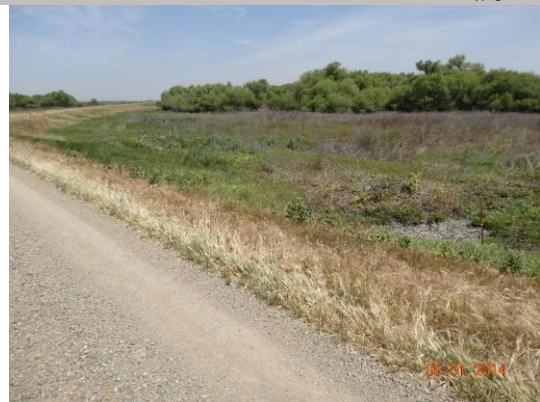
Photo 1 of 3 : UCIP\_SP\_2017\_36517\_66167.jpg

Comment Code					
Inspector Comment					
FS_ID:36517					
DS_ID:19668					
EP_NO: N/A					
Repair Type: Non-Urgent					
Crossing Status: Found					
UCIP Comments: Dense vegetation limits the inspector's visibility to identify signs of pipe failure (leaks) along the slope. Recommend removing vegetation along pipe alignment to conduct proper inspection of structure.					
FIELD_STRUCT_DESC: 24-inch CM pipe through the levee, 8.0 feet below the crown. Flap gate on the waterward end. Brass cap No. 125 BM on headwall on the landward side. (USACE-1967). This entry matches the Drainage or Irrigation Structure referenced in O&M manual (HLM 5.43).					
FS Date: 5/1/2014

View of waterward side.

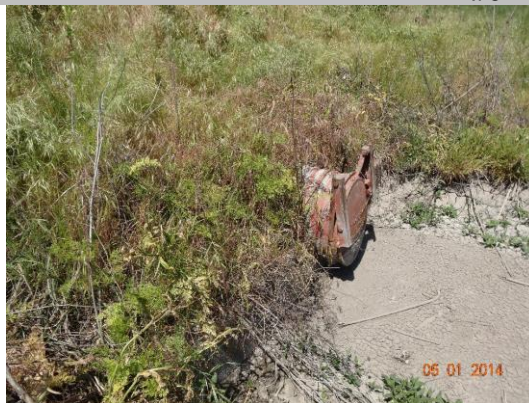
Photo 2 of 3 : UCIP\_SP\_2017\_36517\_66166.jpg

Flap gate visible on waterward side.

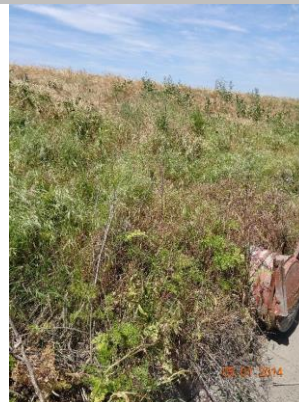
Photo 3 of 3 : UCIP\_SP\_2017\_36517\_66165.jpg

View of waterward slope covered by vegetation.

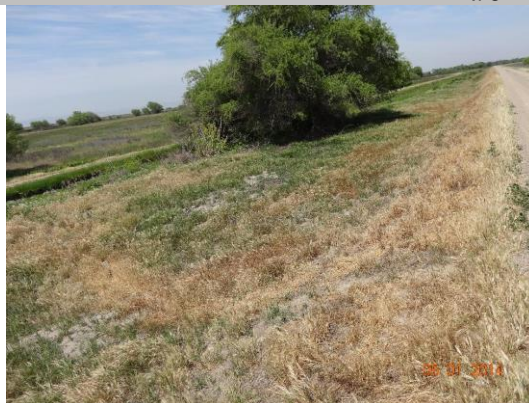
Photo 1 of 2 : UCIP\_SP\_2017\_36518\_66171.jpg

LM Start	6.03	Rating **	M	Issue No.	44
LM End	6.03	Issue Type +	Ma	Location *	LS
Category	Supplemental			GPS Latitude/Longitude	
				Start	End
Item	DWR UCIP LMA Responsibility			37.253527 °	37.253527 °
				-120.823991 °	-120.823991 °
DWR ID					
Comment Code					
Inspector Comment					
FS_ID:36518 DS_ID:19669 EP_NO: N/A Repair Type: Non-Urgent Crossing Status: Found UCIP Comments: Dense vegetation limits the inspector's visibility to identify signs of pipe failure (leaks) along the slope. Recommend removing vegetation along pipe alignment to conduct proper inspection of structure. FIELD_STRUCT_DESC: 24-inch CM pipe through the levee, 7.7 feet below the crown. Flap gate on the waterward end. Brass cap No. 125 BM on headwall on the landward side. (USACE-1967). This entry matches the Drainage or Irrigation Structure referenced in O&M manual (HLM 6.06). FS Date: 5/1/2014

View of landward side.

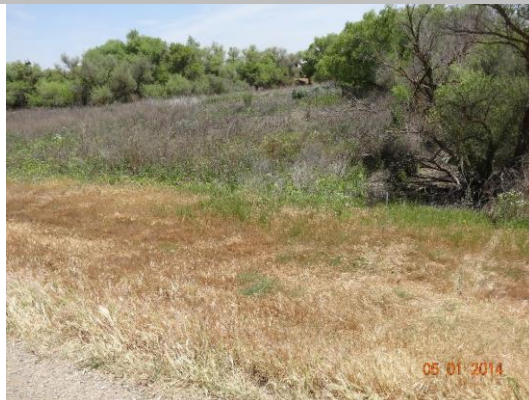
Photo 2 of 2 : UCIP\_SP\_2017\_36518\_66170.jpg

View of waterward side.

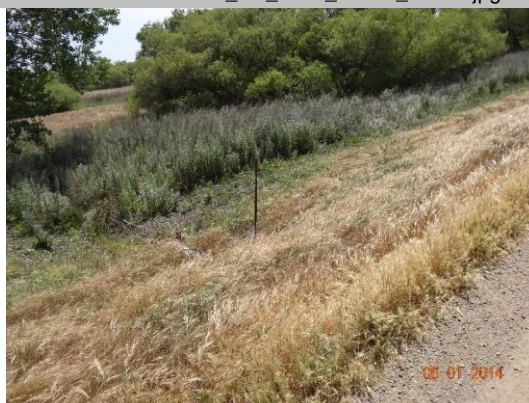
Photo 1 of 3 : UCIP\_SP\_2017\_36519\_66173.jpg

LM Start	6.47	Rating **	M	Issue No.	45
LM End	6.47	Issue Type +	Ma	Location *	LS
Category	Supplemental			GPS Latitude/Longitude	
				Start	End
Item	DWR UCIP LMA Responsibility			37.248210 °	37.248210 °
				-120.823120 °	-120.823120 °
DWR ID					
Comment Code					
Inspector Comment					
FS_ID:36519 DS_ID:19670 EP_NO: N/A Repair Type: Non-Urgent Crossing Status: Found UCIP Comments: Dense vegetation limits the inspector's visibility to identify signs of pipe failure (leaks) along the slope. Recommend removing vegetation along pipe alignment to conduct proper inspection of structure. FIELD_STRUCT_DESC: 24-inch CM pipe through the levee, 7.7 feet below the crown. Flap gate on the waterward end. Brass cap No. 125 BM on headwall on the landward side. (USACE-1967). This entry matches the Drainage or Irrigation Structure referenced in O&M manual (HLM 6.50). FS Date: 5/1/2014

View of waterward side.

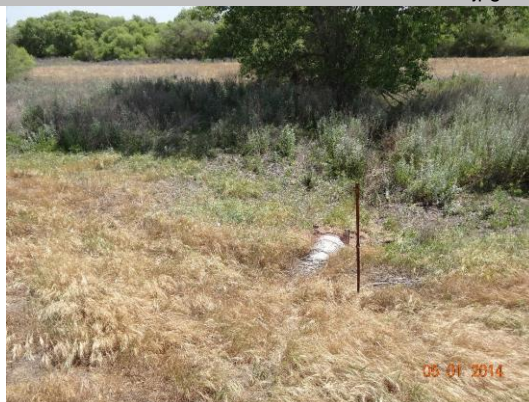
Photo 2 of 3 : UCIP\_SP\_2017\_36519\_66172.jpg

Crossing and flap gate visible on waterward side.

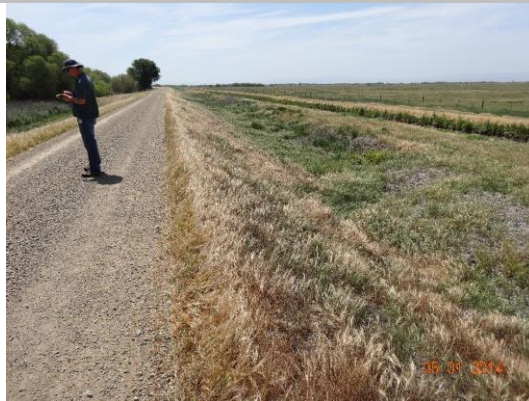
Photo 3 of 3 : UCIP\_SP\_2017\_36519\_66174.jpg

Comment Code						
Inspector Comment						
FS_ID:36519						
DS_ID:19670						
EP_NO: N/A						
Repair Type: Non-Urgent						
Crossing Status: Found						
UCIP Comments: Dense vegetation limits the inspector's visibility to identify signs of pipe failure (leaks) along the slope. Recommend removing vegetation along pipe alignment to conduct proper inspection of structure.						
FIELD_STRUCT_DESC: 24-inch CM pipe through the levee, 7.7 feet below the crown. Flap gate on the waterward end. Brass cap No. 125 BM on headwall on the landward side. (USACE-1967). This entry matches the Drainage or Irrigation Structure referenced in O&M manual (HLM 6.50).						
FS Date: 5/1/2014

Overview of levee crown and landward slope.

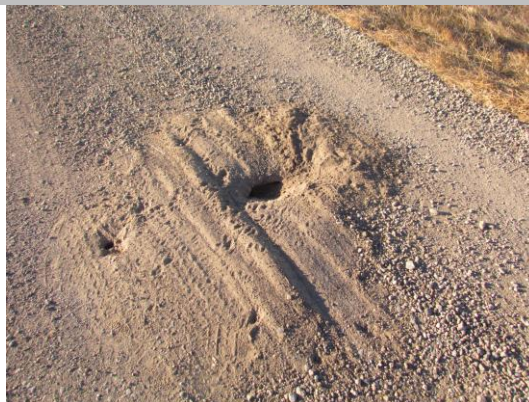
Photo 1 of 2 : SP\_2017\_NA0010\_119\_22\_20170417\_00008.jpg

LM Start	6.85	Rating **	M	Issue No.	22
LM End	6.85	Issue Type +	Ma	Location *	CR
Category	Earthen Levee			GPS Latitude/Longitude	
				Start	End
Item	Animal Control			37.242833 °	37.242833 °
				-120.822270 °	-120.822270 °
DWR ID	DWR_NA0010_02A_f_2016_22				
Comment Code					
A1 : Exterminate rodents and backfill and compact or grout burrows.					
Inspector Comment					
Noticed several burrow holes on the levee crown. It does not seem to be rodent holes or gopher holes. It could be moles.

Looking at rodent hole on levee crown.

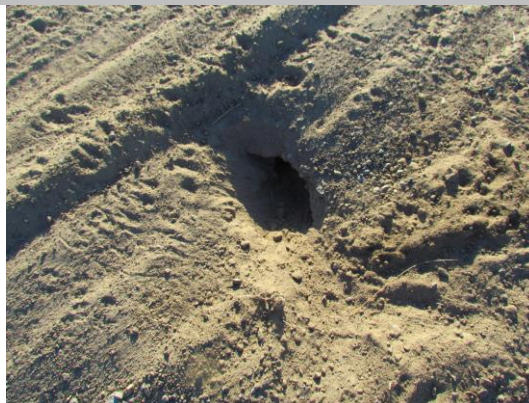
Photo 2 of 2 : SP\_2017\_NA0010\_119\_22\_20170417\_00009.jpg

LM Start	6.85	Rating **	M	Issue No.	22 (cont)	
LM End	6.85	Issue Type +	Ma	Location *	CR	
Category	Earthen Levee			GPS Latitude/Longitude		
				Start		End
Item	Animal Control			37.242833 °		37.242833 °
				-120.822270 °		-120.822270 °
DWR ID	DWR_NA0010_02A_f_2016_22					
Comment Code						
A1 : Exterminate rodents and backfill and compact or grout burrows.						
Inspector Comment						
Noticed several burrow holes on the levee crown. It does not seem to be rodent holes or gopher holes. It could be moles.

Looking at close-up of rodent hole on levee crown.

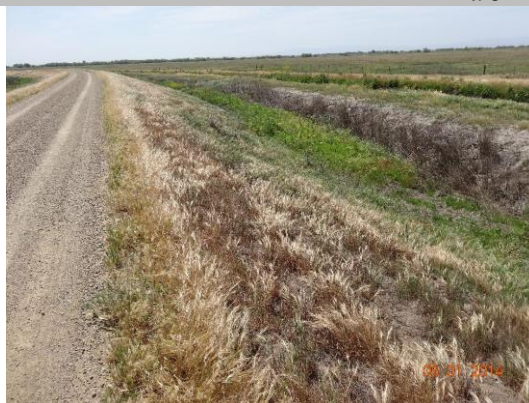
Photo 1 of 3 : UCIP\_SP\_2017\_39365\_66178.jpg

Comment Code					
Inspector Comment					
FS_ID:39365 DS_ID:19671 EP_NO: N/A Repair Type: Non-Urgent Crossing Status: Found UCIP Comments: Dense vegetation limits the inspector's visibility to identify signs of pipe failure (leaks) along the slope. Recommend removing vegetation along pipe alignment to conduct proper inspection of structure. Pipe extension visible on landward side--need to contact owner for additional information about extension/modification. FIELD_STRUCT_DESC: 24-inch CM pipe through the levee, 12.6 feet below the crown. Flap gate on the waterward end. Brass cap No. 125 BM on headwall on the landward side. (USACE-1967). This entry matches the Drainage or Irrigation Structure referenced in O&M manual (HLM 7.05). FS Date: 5/1/2014

View of landward side.

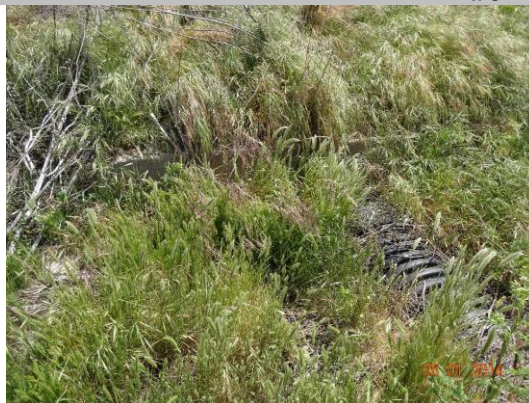
Photo 2 of 3 : UCIP\_SP\_2017\_39365\_66177.jpg

Comment Code						
Inspector Comment						
FS_ID:39365 DS_ID:19671 EP_NO: N/A Repair Type: Non-Urgent Crossing Status: Found UCIP Comments: Dense vegetation limits the inspector's visibility to identify signs of pipe failure (leaks) along the slope. Recommend removing vegetation along pipe alignment to conduct proper inspection of structure. Pipe extension visible on landward side--need to contact owner for additional information about extension/modification. FIELD_STRUCT_DESC: 24-inch CM pipe through the levee, 12.6 feet below the crown. Flap gate on the waterward end. Brass cap No. 125 BM on headwall on the landward side. (USACE-1967). This entry matches the Drainage or Irrigation Structure referenced in O&M manual (HLM 7.05). FS Date: 5/1/2014

Pipe extension visible on landward side attached to inlet at concrete headwall.

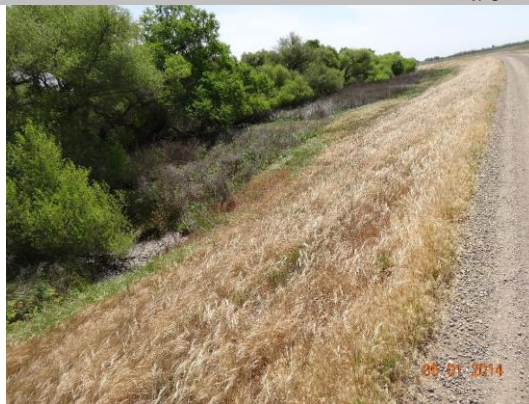
Photo 3 of 3 : UCIP\_SP\_2017\_39365\_66176.jpg

View of waterward side.

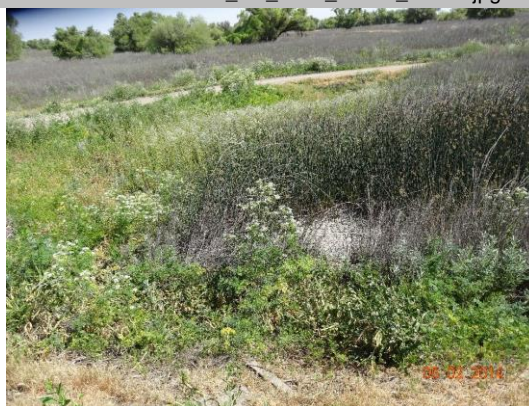
Photo 1 of 3 : UCIP\_SP\_2017\_36521\_66183.jpg

FS\_ID:36521  
DS\_ID:19673  
EP\_NO: N/A  
Repair Type: Non-Urgent  
Crossing Status: Found  
UCIP Comments: Dense vegetation limits the inspector's visibility to identify signs of pipe failure (leaks) along the slope. Recommend removing vegetation along pipe alignment to conduct proper inspection of structure.  
FIELD\_STRUCT\_DESC: 24-inch CM pipe through the levee, 8.0 feet below the crown. Flap gate on the waterward end. Brass cap No. 125 BM on headwall on the landward side. (USACE-1967). This entry matches the Drainage or Irrigation Structure referenced in O&M manual (HLM 7.77).  
FS Date: 5/1/2014

View of waterward side.

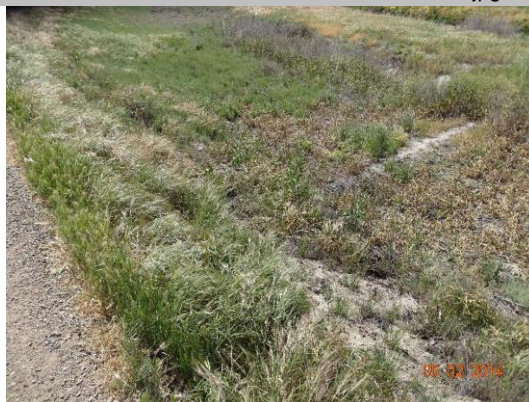
Photo 2 of 3 : UCIP\_SP\_2017\_36521\_66182.jpg

View of landward side.

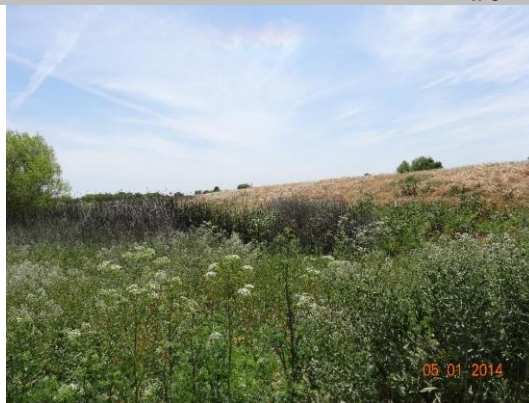
Photo 3 of 3 : UCIP\_SP\_2017\_36521\_66181.jpg

Comment Code						
Inspector Comment						
FS_ID:36521 DS_ID:19673 EP_NO: N/A Repair Type: Non-Urgent Crossing Status: Found UCIP Comments: Dense vegetation limits the inspector's visibility to identify signs of pipe failure (leaks) along the slope. Recommend removing vegetation along pipe alignment to conduct proper inspection of structure. FIELD_STRUCT_DESC: 24-inch CM pipe through the levee, 8.0 feet below the crown. Flap gate on the waterward end. Brass cap No. 125 BM on headwall on the landward side. (USACE-1967). This entry matches the Drainage or Irrigation Structure referenced in O&M manual (HLM 7.77). FS Date: 5/1/2014

View of waterward side--photo taken from levee toe looking towards alignment of crossing.

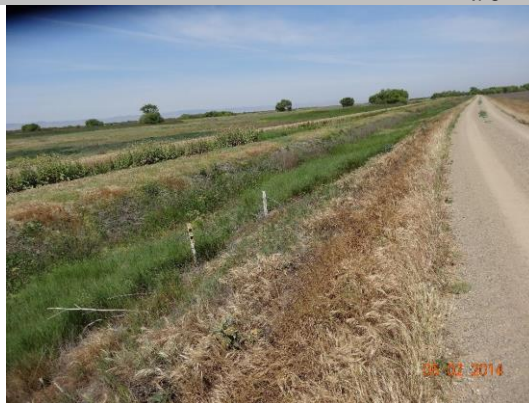
Photo 1 of 3 : UCIP\_SP\_2017\_39366\_66184.jpg

Comment Code					
Inspector Comment					
FS_ID:39366 DS_ID:19674 EP_NO: N/A Repair Type: Non-Urgent Crossing Status: Found UCIP Comments: Dense vegetation limits the inspector's visibility to identify signs of pipe failure (leaks) along the slope and landward headwall. Recommend removing vegetation along pipe alignment and toe to conduct proper inspection of structure. Sediment buildup in pipe visible from landward side--recommend clearing. FIELD_STRUCT_DESC: 24-inch CM pipe through the levee, 9.0 feet below the crown. Flap gate on the waterward end. Brass cap No. 120 BM on headwall on the landward side. (USACE-1967). This entry matches the Drainage or Irrigation Structure referenced in O&M manual (HLM 8.16). FS Date: 5/14/2014

View of landward side.

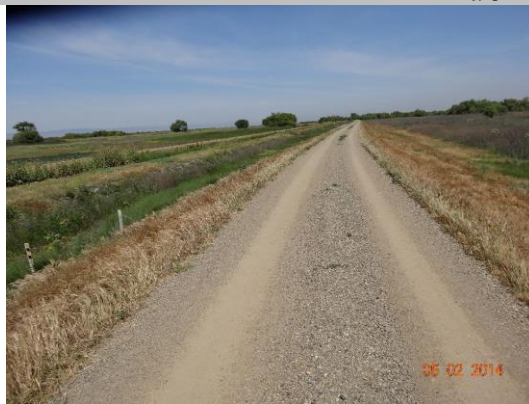
Photo 2 of 3 : UCIP\_SP\_2017\_39366\_66185.jpg

Overview of levee crown at crossing.
