**Flood Control Project Maintenance  
Levee Inspections**  
**LMA District Cover Sheet**  
**Spring 2017 Levee Inspection Results**

**Lower San Joaquin Levee District**

Waterway			Bank	Unit Miles
Unit No. 01 San Joaquin River			Right	22.52
	Spring (March - May)	Summer (June - August)	(September - November) Fall	Winter (December - February)
Unit Maintenance Rating (Fall Only)				
Date of Inspection	4/17/2017 - 4/20/2017			
DWR Inspector	Richard Willoughby			
Accompanied By

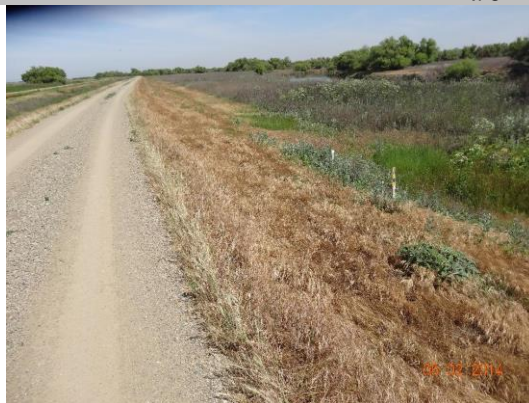
Photo 3 of 3 : UCIP\_SP\_2017\_39366\_66186.jpg

Comment Code					
Inspector Comment					
FS_ID:39366 DS_ID:19674 EP_NO: N/A Repair Type: Non-Urgent Crossing Status: Found UCIP Comments: Dense vegetation limits the inspector's visibility to identify signs of pipe failure (leaks) along the slope and landward headwall. Recommend removing vegetation along pipe alignment and toe to conduct proper inspection of structure. Sediment buildup in pipe visible from landward side--recommend clearing. FIELD_STRUCT_DESC: 24-inch CM pipe through the levee, 9.0 feet below the crown. Flap gate on the waterward end. Brass cap No. 120 BM on headwall on the landward side. (USACE-1967). This entry matches the Drainage or Irrigation Structure referenced in O&M manual (HLM 8.16). FS Date: 5/14/2014

View of waterward side.

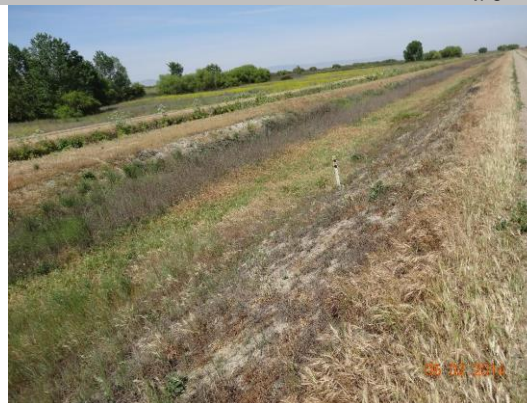
Photo 1 of 3 : UCIP\_SP\_2017\_39367\_66195.jpg

Comment Code					
Inspector Comment					
FS_ID:39367 DS_ID:19675 EP_NO: N/A Repair Type: Non-Urgent Crossing Status: Found UCIP Comments: Dense vegetation on landward toe. Also dense vegetation limits the inspector's visibility to identify signs of pipe failure (leaks) along waterward slope. Recommend removing vegetation along pipe alignment toe to conduct proper inspection of structure. Sediment buildup in pipe--recommend clearing. FIELD_STRUCT_DESC: 24-inch CM pipe through the levee, 9.4 feet below the crown. Flap gate on the waterward end. Brass cap No. 120 BM on headwall on the landward side. (USACE-1967). This entry matches the Drainage or Irrigation Structure referenced in O&M manual (HLM 8.48). FS Date: 5/14/2014

View of landward side.

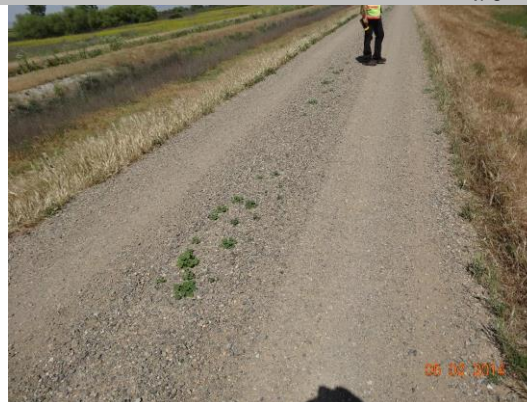
Photo 2 of 3 : UCIP\_SP\_2017\_39367\_66193.jpg

Overview of levee crown at crossing.

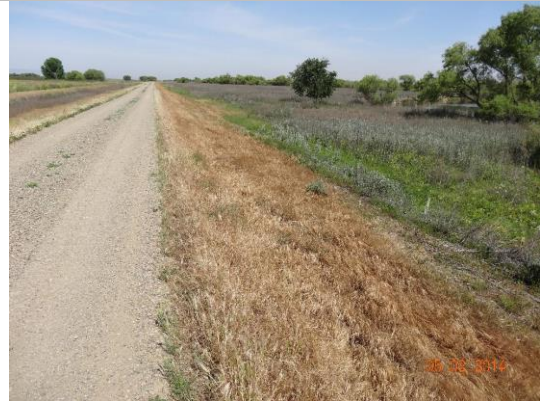
Photo 3 of 3 : UCIP\_SP\_2017\_39367\_66194.jpg

Comment Code					
Inspector Comment					
FS_ID:39367 DS_ID:19675 EP_NO: N/A Repair Type: Non-Urgent Crossing Status: Found UCIP Comments: Dense vegetation on landward toe. Also dense vegetation limits the inspector's visibility to identify signs of pipe failure (leaks) along waterward slope. Recommend removing vegetation along pipe alignment toe to conduct proper inspection of structure. Sediment buildup in pipe--recommend clearing. FIELD_STRUCT_DESC: 24-inch CM pipe through the levee, 9.4 feet below the crown. Flap gate on the waterward end. Brass cap No. 120 BM on headwall on the landward side. (USACE-1967). This entry matches the Drainage or Irrigation Structure referenced in O&M manual (HLM 8.48). FS Date: 5/14/2014

View of waterward side.

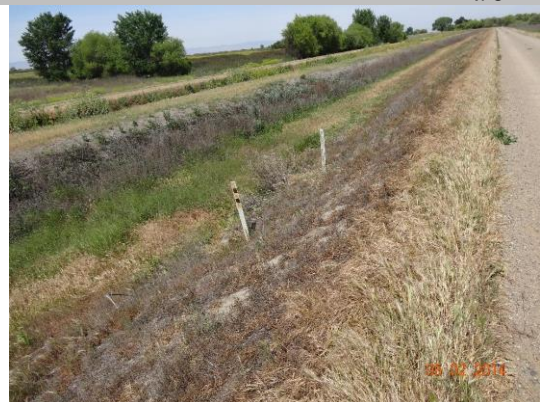
Photo 1 of 3 : UCIP\_SP\_2017\_42503\_66200.jpg

Comment Code					
Inspector Comment					
FS_ID:42503 DS_ID:19676 EP_NO: N/A Repair Type: Non-Urgent Crossing Status: Found UCIP Comments: Dense vegetation limits the inspector's visibility to identify signs of pipe failure (leaks) along the slope. Recommend removing vegetation along pipe alignment to conduct proper inspection of structure. Burrow activity presen on waterward slope. FIELD_STRUCT_DESC: 24-inch CM pipe through the levee, 8.8 feet below the crown. Flap gate on the waterward end. Brass cap No. 120 BM on headwall on the landward side. (USACE-1967). This entry matches the Drainage or Irrigation Structure referenced in O&M manual (HLM 8.86). FS Date: 5/14/2014

View of landward side.

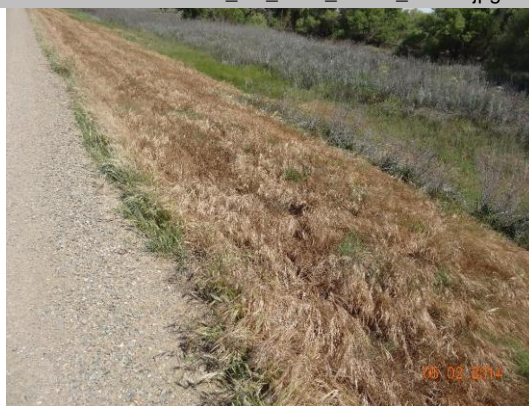
Photo 2 of 3 : UCIP\_SP\_2017\_42503\_66199.jpg

Item	DWR UCIP LMA Responsibility			37.222271 °		37.222271 °
				-120.798705 °		-120.798705 °
DWR ID						
Comment Code						
Inspector Comment						
FS_ID:42503 DS_ID:19676 EP_NO: N/A Repair Type: Non-Urgent Crossing Status: Found UCIP Comments: Dense vegetation limits the inspector's visibility to identify signs of pipe failure (leaks) along the slope. Recommend removing vegetation along pipe alignment to conduct proper inspection of structure. Burrow activity presen on waterward slope. FIELD_STRUCT_DESC: 24-inch CM pipe through the levee, 8.8 feet below the crown. Flap gate on the waterward end. Brass cap No. 120 BM on headwall on the landward side. (USACE-1967). This entry matches the Drainage or Irrigation Structure referenced in O&M manual (HLM 8.86). FS Date: 5/14/2014

View of waterward side.

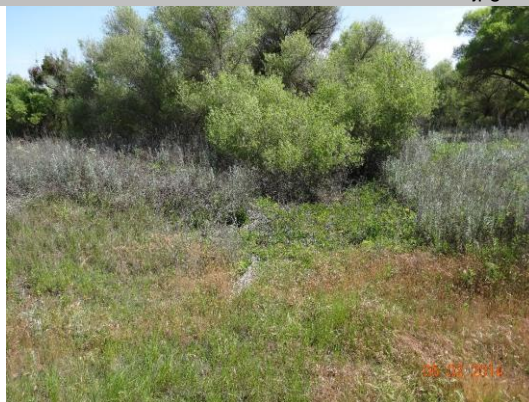
Photo 3 of 3 : UCIP\_SP\_2017\_42503\_66201.jpg

View of waterward toe.

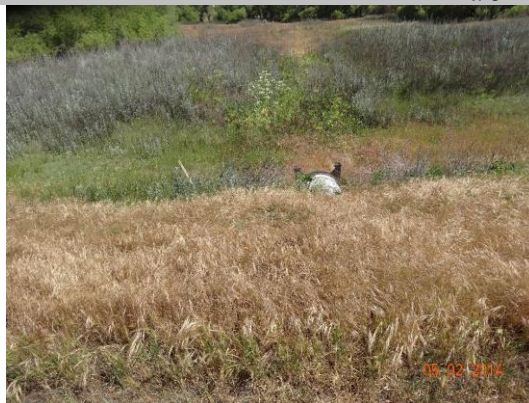
Photo 1 of 3 : UCIP\_SP\_2017\_36525\_66208.jpg

LM Start	9.00	Rating **	M	Issue No.	171
LM End	9.00	Issue Type +	Ma	Location *	CR
Category	Supplemental			GPS Latitude/Longitude	
				Start	End
Item	DWR UCIP LMA Responsibility			37.220888 °	37.220888 °
				-120.796394 °	-120.796394 °
DWR ID					
Comment Code					
Inspector Comment					
FS_ID:36525 DS_ID:19677 EP_NO: N/A Repair Type: Non-Urgent Crossing Status: Found UCIP Comments: Dense vegetation limits the inspector's visibility to identify signs of pipe failure (leaks) along the slope. Recommend removing vegetation along pipe alignment to conduct proper inspection of structure. FIELD_STRUCT_DESC: 36-inch CM pipe through the levee, 8.8 feet below the crown. Flap gate on the waterward end. Brass cap No. 120 BM on headwall on the landward side. (USACE-1967). This entry matches the Drainage or Irrigation Structure referenced in O&M manual (HLM 9.02). FS Date: 5/14/2014

View of waterward side--pipe and flap gate visible.

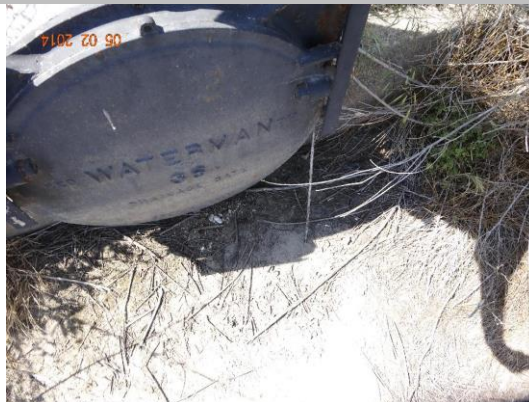
Photo 2 of 3 : UCIP\_SP\_2017\_36525\_66207.jpg

View of flap gate visible from waterward side.

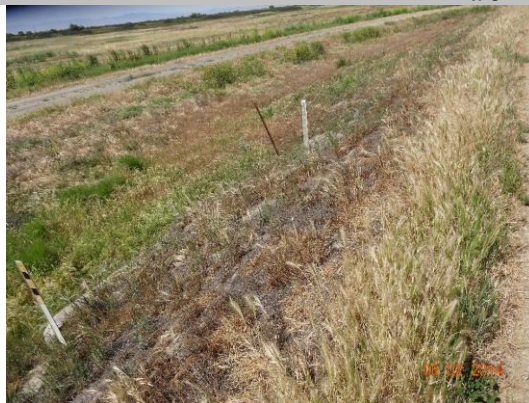
Photo 3 of 3 : UCIP\_SP\_2017\_36525\_66206.jpg

Item	DWR UCIP LMA Responsibility			37.220888 °	37.220888 °	
				-120.796394 °	-120.796394 °	
DWR ID						
Comment Code						
Inspector Comment						
FS_ID:36525 DS_ID:19677 EP_NO: N/A Repair Type: Non-Urgent Crossing Status: Found UCIP Comments: Dense vegetation limits the inspector's visibility to identify signs of pipe failure (leaks) along the slope. Recommend removing vegetation along pipe alignment to conduct proper inspection of structure. FIELD_STRUCT_DESC: 36-inch CM pipe through the levee, 8.8 feet below the crown. Flap gate on the waterward end. Brass cap No. 120 BM on headwall on the landward side. (USACE-1967). This entry matches the Drainage or Irrigation Structure referenced in O&M manual (HLM 9.02). FS Date: 5/14/2014

View of landward side.

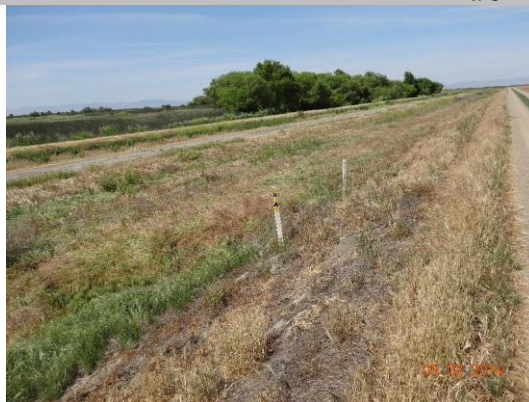
Photo 1 of 3 : UCIP\_SP\_2017\_40443\_66211.jpg

LM Start	9.17	Rating **	M	Issue No.	172
LM End	9.17	Issue Type +	Ma	Location *	CR
Category	Supplemental			GPS Latitude/Longitude	
				Start	End
Item	DWR UCIP LMA Responsibility			37.220520 °	37.220520 °
				-120.793277 °	-120.793277 °
DWR ID					
Comment Code					
Inspector Comment					
FS_ID:40443 DS_ID:19678 EP_NO: N/A Repair Type: Non-Urgent Crossing Status: Found UCIP Comments: Dense vegetation limits the inspector's visibility to identify signs of pipe failure (leaks) along the slope. Recommend removing vegetation along pipe alignment to conduct proper inspection of structure. FIELD_STRUCT_DESC: 24-inch CM pipe through the levee, 8.0 feet below the crown. Flap gate on the waterward end. Brass cap No. 120 BM on headwall on the landward side. (USACE-1967). This entry matches the Drainage or Irrigation Structure referenced in O&M manual (HLM 9.20). FS Date: 5/14/2014

View of landward side.

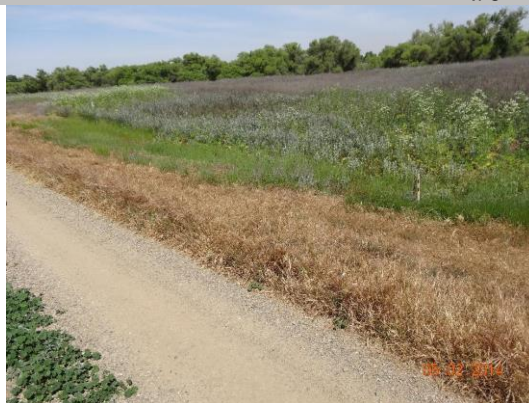
Photo 2 of 3 : UCIP\_SP\_2017\_40443\_66210.jpg

Item	DWR UCIP LMA Responsibility			37.220520 °		37.220520 °
				-120.793277 °		-120.793277 °
DWR ID						
Comment Code						
Inspector Comment						
FS_ID:40443 DS_ID:19678 EP_NO: N/A Repair Type: Non-Urgent Crossing Status: Found UCIP Comments: Dense vegetation limits the inspector's visibility to identify signs of pipe failure (leaks) along the slope. Recommend removing vegetation along pipe alignment to conduct proper inspection of structure. FIELD_STRUCT_DESC: 24-inch CM pipe through the levee, 8.0 feet below the crown. Flap gate on the waterward end. Brass cap No. 120 BM on headwall on the landward side. (USACE-1967). This entry matches the Drainage or Irrigation Structure referenced in O&M manual (HLM 9.20). FS Date: 5/14/2014

View of waterward side.

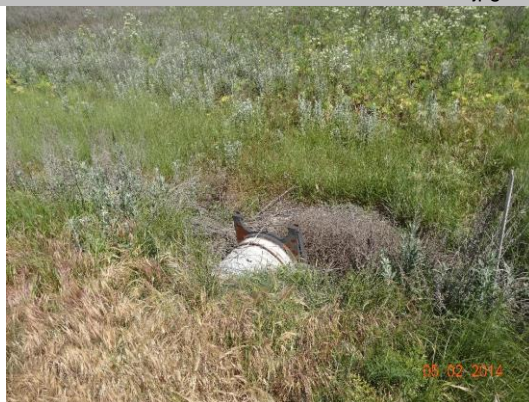
Photo 3 of 3 : UCIP\_SP\_2017\_40443\_66209.jpg

Pipe visible on waterward side.

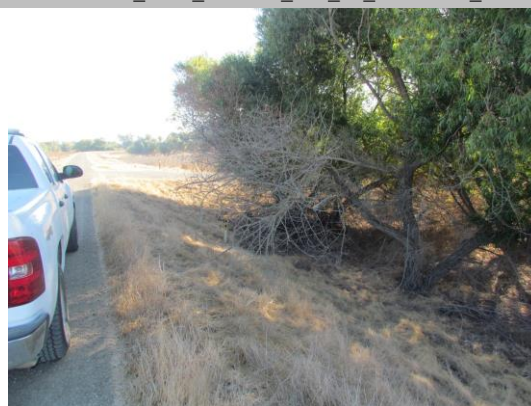
Photo 1 of 1 : SP\_2017\_NA0010\_120\_17\_20170417\_00005.jpg

LM Start	9.42	Rating **	M	Issue No.	17
LM End	9.42	Issue Type +	Ma	Location *	LS
Category	Earthen Levee			GPS Latitude/Longitude	
				Start	End
Item	Trim / Thin Trees			37.220199°	37.220199°
				-120.788748°	-120.788748°
DWR ID	DWR_NA0010_02B_f_2016_17				
Comment Code					
T1 : Trim trees to at least five feet above ground level.					
Inspector Comment					
Trim back dead tree limb on landward toe.

Looking at dead tree limb on landward slope.

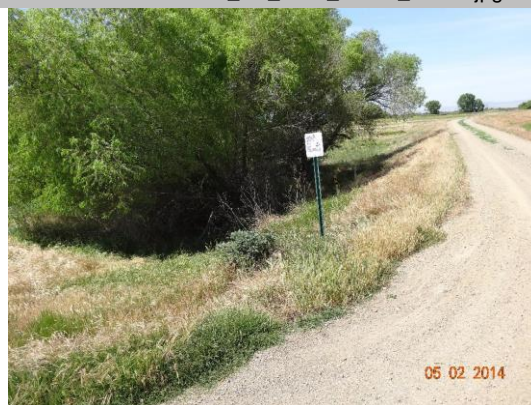
Photo 1 of 3 : UCIP\_SP\_2017\_36527\_66217.jpg

LM Start	9.43	Rating **	M	Issue No.	173
LM End	9.43	Issue Type +	Ma	Location *	LS
Category	Supplemental			GPS Latitude/Longitude	
				Start	End
Item	DWR UCIP LMA Responsibility			37.220227 °	37.220227 °
				-120.788634 °	-120.788634 °
DWR ID					
Comment Code					
Inspector Comment					
FS_ID:36527 DS_ID:19686 EP_NO: N/A Repair Type: Non-Urgent Crossing Status: Found UCIP Comments: Dense vegetation limits the inspector's visibility to identify signs of pipe failure (leaks) along the slope. Recommend removing vegetation along pipe alignment to conduct proper inspection of structure. FIELD_STRUCT_DESC: 24-inch CM pipe through the levee, 9.0 feet below the crown. Flap gate on the waterward end. Brass cap No. 115 BM on headwall on the landward side. (USACE-1967). This entry matches the Drainage or Irrigation Structure referenced in O&M manual (HLM 9.46). FS Date: 5/14/2014

View of landward side.

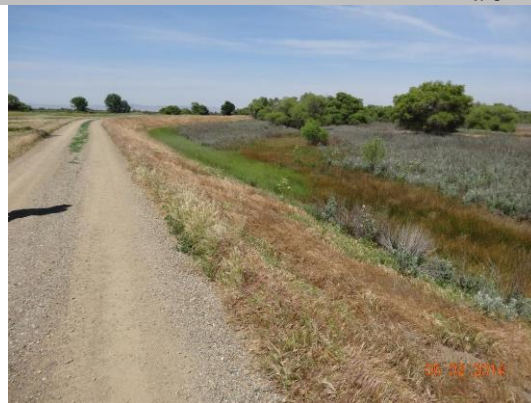
Photo 2 of 3 : UCIP\_SP\_2017\_36527\_66216.jpg

Item	DWR UCIP LMA Responsibility			37.220227 °	37.220227 °	
				-120.788634 °	-120.788634 °	
DWR ID						
Comment Code						
Inspector Comment						
FS_ID:36527						
DS_ID:19686						
EP_NO: N/A						
Repair Type: Non-Urgent						
Crossing Status: Found						
UCIP Comments: Dense vegetation limits the inspector's visibility to						
identify signs of pipe failure (leaks) along the slope. Recommend						
removing vegetation along pipe alignment to conduct proper inspection						
of structure.						
FIELD_STRUCT_DESC: 24-inch CM pipe through the levee, 9.0 feet						
below the crown. Flap gate on the waterward end. Brass cap No. 115						
BM on headwall on the landward side. (USACE-1967). This entry						
matches the Drainage or Irrigation Structure referenced in O&M manual						
(HLM 9.46).						
FS Date: 5/14/2014

View of waterward side.

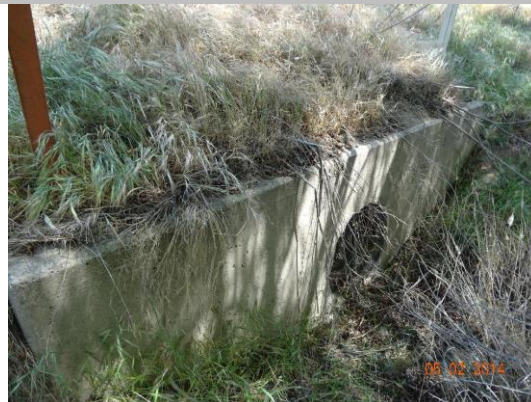
Photo 3 of 3 : UCIP\_SP\_2017\_36527\_66215.jpg

Concrete headwall visible on landward side.

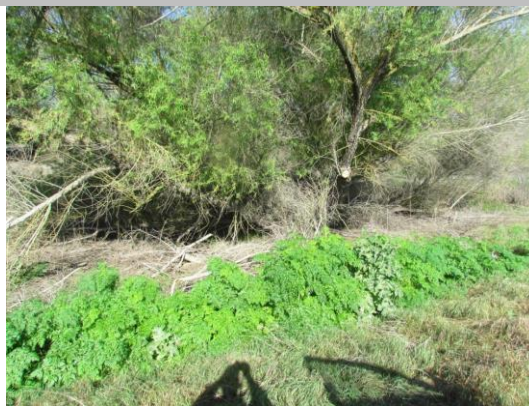
Photo 1 of 1 : SP\_2017\_NA0010\_120\_23\_20170424\_00009.jpg

LM Start	9.75	Rating **	U	Issue No.	23
LM End	9.75	Issue Type +	Ma	Location *	LS
Category	Earthen Levee			GPS Latitude/Longitude	
				Start	End
Item	Trim / Thin Trees			37.219083 °	37.219083 °
				-120.784327 °	-120.784327 °
DWR ID	DWR_NA0010_02B_s_2017_23				
Comment Code					
T1 : Trim trees to at least five feet above ground level.					
Inspector Comment

Looking west at untrimmed trees at landward toe.

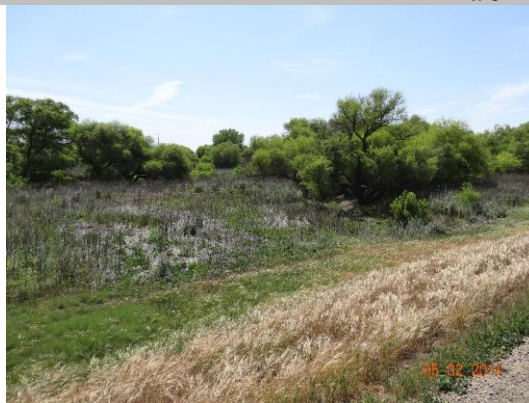
Photo 1 of 3 : UCIP\_SP\_2017\_36528\_66224.jpg

LM Start	10.09	Rating **	M	Issue No.	174
LM End	10.09	Issue Type +	Ma	Location *	LS
Category	Supplemental			GPS Latitude/Longitude	
				Start	End
Item	DWR UCIP LMA Responsibility			37.214229 °	37.214229 °
				-120.784350 °	-120.784350 °
DWR ID					
Comment Code					
Inspector Comment					
FS_ID:36528 DS_ID:19687 EP_NO: N/A Repair Type: Non-Urgent Crossing Status: Found UCIP Comments: Dense vegetation limits the inspector's visibility to identify signs of pipe failure (leaks) along the slope. Recommend removing vegetation along pipe alignment to conduct proper inspection of structure. FIELD_STRUCT_DESC: 24-inch CM pipe through the levee, 11.7 feet below the crown. Flap gate on the waterward end. Brass cap No. 115 BM on headwall on the landward side. (USACE-1967). This entry matches the Drainage or Irrigation Structure referenced in O&M manual (HLM 10.12). FS Date: 5/14/2014

Overview of waterward side.

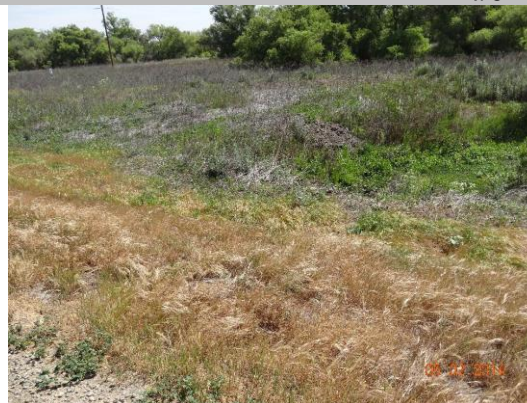
Photo 3 of 3 : UCIP\_SP\_2017\_36528\_66222.jpg

Item	DWR UCIP LMA Responsibility			37.214229 °		37.214229 °
				-120.784350 °		-120.784350 °
DWR ID						
Comment Code						
Inspector Comment						
FS_ID:36528						
DS_ID:19687						
EP_NO: N/A						
Repair Type: Non-Urgent						
Crossing Status: Found						
UCIP Comments: Dense vegetation limits the inspector's visibility to identify signs of pipe failure (leaks) along the slope. Recommend removing vegetation along pipe alignment to conduct proper inspection of structure.						
FIELD_STRUCT_DESC: 24-inch CM pipe through the levee, 11.7 feet below the crown. Flap gate on the waterward end. Brass cap No. 115 BM on headwall on the landward side. (USACE-1967). This entry matches the Drainage or Irrigation Structure referenced in O&M manual (HLM 10.12).						
FS Date: 5/14/2014

View of waterward side.

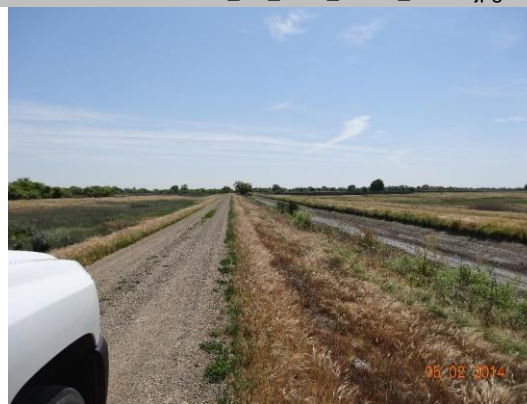
Photo 1 of 3 : UCIP\_SP\_2017\_42504\_66231.jpg

Comment Code					
Inspector Comment					
FS_ID:42504					
DS_ID:19688					
EP_NO: N/A					
Repair Type: Non-Urgent					
Crossing Status: Found					
UCIP Comments: Dense vegetation limits the inspector's visibility to identify signs of pipe failure (leaks) along the slope. Recommend removing vegetation along pipe alignment to conduct proper inspection of structure. Sediment buildup in pipe visible on landward side--recommend clearing.					
FIELD_STRUCT_DESC: 24-inch CM pipe through the levee, 8.0 feet below the crown. Flap gate on the waterward end. Slide gate on the landward end. Brass cap No. 115 BM on headwall on the landward side. (USACE-1967). This entry matches the Drainage or Irrigation Structure referenced in O&M manual (HLM 10.81).					
FS Date: 5/14/2014

View of landward side.

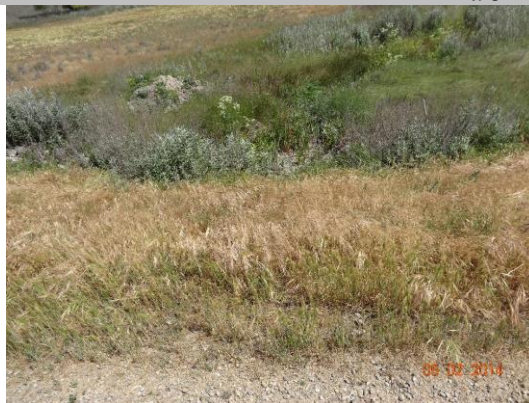
Photo 2 of 3 : UCIP\_SP\_2017\_42504\_66232.jpg

Item	DWR UCIP LMA Responsibility			37.206352 °	37.206352 °	
				-120.777634 °	-120.777634 °	
DWR ID						
Comment Code						
Inspector Comment						
FS_ID:42504						
DS_ID:19688						
EP_NO: N/A						
Repair Type: Non-Urgent						
Crossing Status: Found						
UCIP Comments: Dense vegetation limits the inspector's visibility to identify signs of pipe failure (leaks) along the slope. Recommend removing vegetation along pipe alignment to conduct proper inspection of structure. Sediment buildup in pipe visible on landward side--recommend clearing.						
FIELD_STRUCT_DESC: 24-inch CM pipe through the levee, 8.0 feet below the crown. Flap gate on the waterward end. Slide gate on the landward end. Brass cap No. 115 BM on headwall on the landward side. (USACE-1967). This entry matches the Drainage or Irrigation Structure referenced in O&M manual (HLM 10.81).						
FS Date: 5/14/2014

View of waterward side.

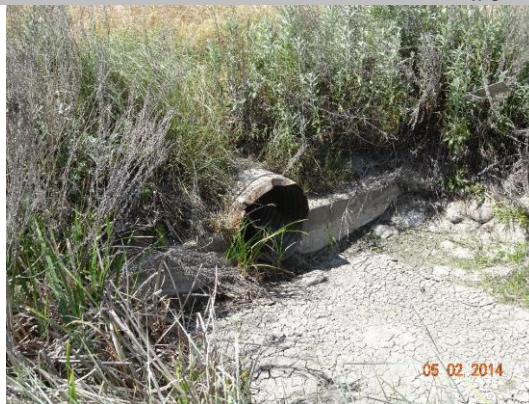
Photo 3 of 3 : UCIP\_SP\_2017\_42504\_66234.jpg

View of pipe visible on waterward side.

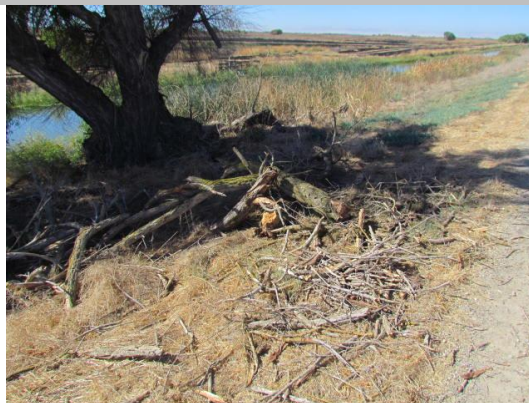
Photo 1 of 1 : SP\_2017\_NA0010\_120\_14\_20170417\_00004.jpg

LM Start	10.94	Rating **	M	Issue No.	14	
LM End	10.94	Issue Type +	Ma	Location *	LS	
Category	Earthen Levee			GPS Latitude/Longitude		
				Start		End
Item	Encroachments			37.205711 °		37.205711 °
				-120.774741 °		-120.774741 °
DWR ID	DWR_NA0010_02B_f_2015_14					
Comment Code						
PR : Prunings						
Inspector Comment						
Prunings on landward slope.

Looking at prunings on landward slope.

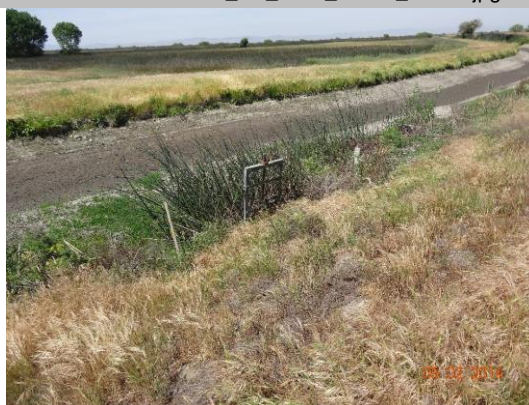
Photo 1 of 3 : UCIP\_SP\_2017\_36530\_66236.jpg

Comment Code					
Inspector Comment					
FS_ID:36530 DS_ID:19689 EP_NO: N/A Repair Type: Non-Urgent Crossing Status: Found UCIP Comments: Dense vegetation limits the inspector's visibility to identify signs of pipe failure (leaks) along the slope. Recommend removing vegetation along pipe alignment to conduct proper inspection of structure. FIELD_STRUCT_DESC: 24-inch CM pipe through the levee, 8.0 feet below the crown. Flap gate on the waterward end. Screw gate on the landward end. Brass cap No. 115 BM on headwall on the landward side. (USACE-1967). This entry matches the Drainage or Irrigation Structure referenced in O&M manual (HLM 11.17). FS Date: 5/14/2014

View of landward slope.

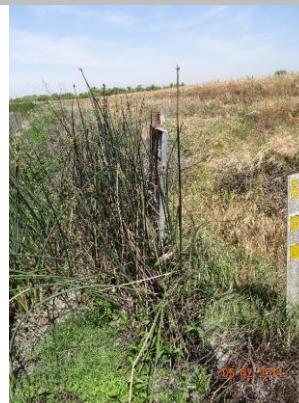
Photo 2 of 3 : UCIP\_SP\_2017\_36530\_66235.jpg

Item	DWR UCIP Field Study			37.204640 °		37.204640 °
				-120.771564 °		-120.771564 °
DWR ID						
Comment Code						
Inspector Comment						
FS_ID:36530 DS_ID:19689 EP_NO: N/A Repair Type: Non-Urgent Crossing Status: Found UCIP Comments: Dense vegetation limits the inspector's visibility to identify signs of pipe failure (leaks) along the slope. Recommend removing vegetation along pipe alignment to conduct proper inspection of structure. FIELD_STRUCT_DESC: 24-inch CM pipe through the levee, 8.0 feet below the crown. Flap gate on the waterward end. Screw gate on the landward end. Brass cap No. 115 BM on headwall on the landward side. (USACE-1967). This entry matches the Drainage or Irrigation Structure referenced in O&M manual (HLM 11.17). FS Date: 5/14/2014

Slide gate visible on landward side blocked by vegetation.

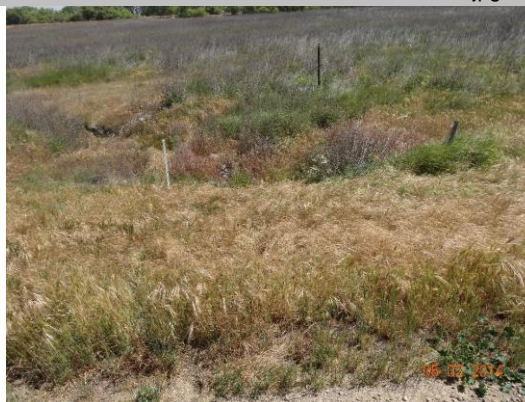
Photo 3 of 3 : UCIP\_SP\_2017\_36530\_66238.jpg

LM Start	11.14	Rating **	M	Issue No.	176 (cont)
LM End	11.14	Issue Type +	En	Location *	LS

View of waterward side.

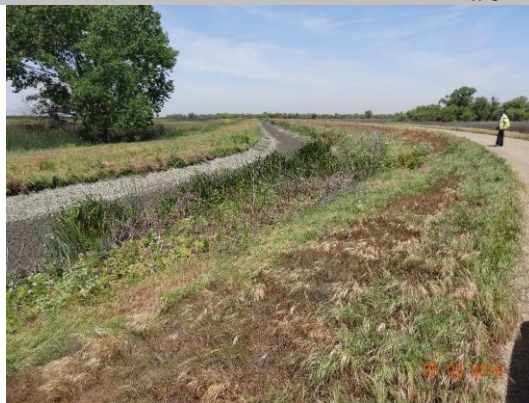
Photo 1 of 3 : UCIP\_SP\_2017\_36531\_66241.jpg

LM Start	11.40	Rating **	M	Issue No.	177
LM End	11.40	Issue Type +	Ma	Location *	LS
Category	Supplemental			GPS Latitude/Longitude	
				Start	End
Item	DWR UCIP LMA Responsibility			37.201792 °	37.201792 °
				-120.768462 °	-120.768462 °
DWR ID					
Comment Code					
Inspector Comment					
FS_ID:36531 DS_ID:19690 EP_NO: N/A Repair Type: Non-Urgent Crossing Status: Found UCIP Comments: Dense vegetation limits the inspector's visibility to identify signs of pipe failure (leaks) along the slope. Recommend removing vegetation along pipe alignment to conduct proper inspection of structure. FIELD_STRUCT_DESC: 24-inch CM pipe through the levee, 8.0 feet below the crown. Flap gate on the waterward end. Screw gate on the landward side. (USACE-1967). This entry matches the Drainage or Irrigation Structure referenced in O&M manual (HLM 11.43). FS Date: 5/14/2014

View of landward side.

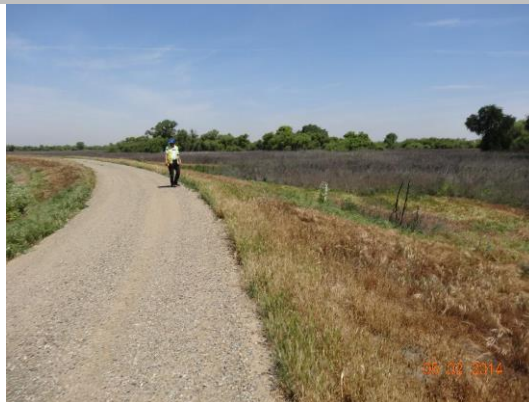
Photo 2 of 3 : UCIP\_SP\_2017\_36531\_66240.jpg

LM Start	<b>11.40</b>	Rating **	M	Issue No.	<b>177 (cont)</b>
LM End	<b>11.40</b>	Issue Type +	Ma	Location *	LS

View of waterward side.

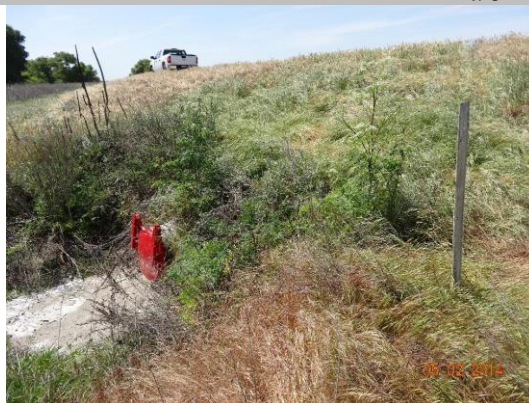
Photo 3 of 3 : UCIP\_SP\_2017\_36531\_66239.jpg

LM Start	11.40	Rating **	M	Issue No.	177 (cont)	
LM End	11.40	Issue Type +	Ma	Location *	LS	
Category	Supplemental			GPS Latitude/Longitude		
				Start		End
Item	DWR UCIP LMA Responsibility			37.201792 °	37.201792 °	
				-120.768462 °	-120.768462 °	
DWR ID						
Comment Code						
Inspector Comment						
FS_ID:36531 DS_ID:19690 EP_NO: N/A Repair Type: Non-Urgent Crossing Status: Found UCIP Comments: Dense vegetation limits the inspector's visibility to identify signs of pipe failure (leaks) along the slope. Recommend removing vegetation along pipe alignment to conduct proper inspection of structure. FIELD_STRUCT_DESC: 24-inch CM pipe through the levee, 8.0 feet below the crown. Flap gate on the waterward end. Screw gate on the landward side. (USACE-1967). This entry matches the Drainage or Irrigation Structure referenced in O&M manual (HLM 11.43). FS Date: 5/14/2014

Flap gate visible on waterward toe.

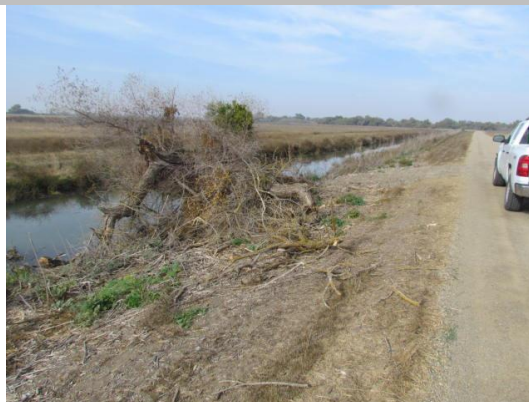
Photo 1 of 2 : SP\_2017\_NA0010\_120\_1\_20170417\_00001.jpg

LM Start	12.21	Rating **	M	Issue No.	1
LM End	12.21	Issue Type +	Ma	Location *	LS
Category	Earthen Levee			GPS Latitude/Longitude	
				Start	End
Item	Encroachments			37.191528 °	37.191528 °
				-120.764541 °	-120.764541 °
DWR ID	DWR_NA0010_02B_f_2014_1				
Comment Code					
TR : Tree or limb					
Inspector Comment					
Fallen tree limbs on landward slope.

Looking northwest at tree limb on waterward slope.

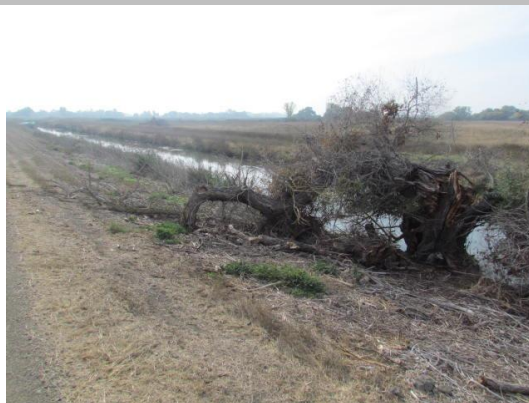
Photo 2 of 2 : SP\_2017\_NA0010\_120\_1\_20170417\_00002.jpg

LM Start	12.21	Rating **	M	Issue No.	1 (cont)	
LM End	12.21	Issue Type +	Ma	Location *	LS	
Category	Earthen Levee			GPS Latitude/Longitude		
				Start		End
Item	Encroachments			37.191528 °		37.191528 °
				-120.764541 °		-120.764541 °
DWR ID	DWR_NA0010_02B_f_2014_1					
Comment Code						
TR : Tree or limb						
Inspector Comment						
Fallen tree limbs on landward slope.

Looking southwest at tree limb on waterward slope.

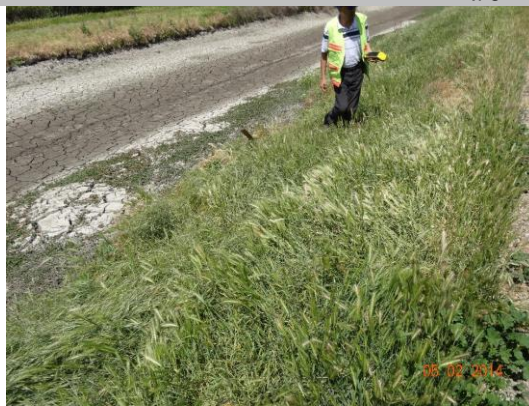
Photo 1 of 3 : UCIP\_SP\_2017\_39370\_66245.jpg

LM Start	13.18	Rating **	M	Issue No.	178
LM End	13.18	Issue Type +	Ma	Location *	LS
Category	Supplemental			GPS Latitude/Longitude	
				Start	End
Item	DWR UCIP LMA Responsibility			37.179265 °	37.179265 °
				-120.764870 °	-120.764870 °
DWR ID					
Comment Code					
Inspector Comment					
FS_ID:39370 DS_ID:19663 EP_NO: N/A Repair Type: Non-Urgent Crossing Status: Found UCIP Comments: Dense vegetation limits the inspector's visibility to identify signs of pipe failure (leaks) along the slope. Recommend removing vegetation along pipe alignment to conduct proper inspection of structure. Sediment buildup in pipe--recommend clearing. FIELD_STRUCT_DESC: 24-inch CM pipe through the levee, 6.5 feet below the crown. Slide gate in pipe riser on the waterward slope. (USACE-1967). This entry matches the Drainage or Irrigation Structure referenced in O&M manual (HLM 13.22). FS Date: 5/14/2014

View of landward side.

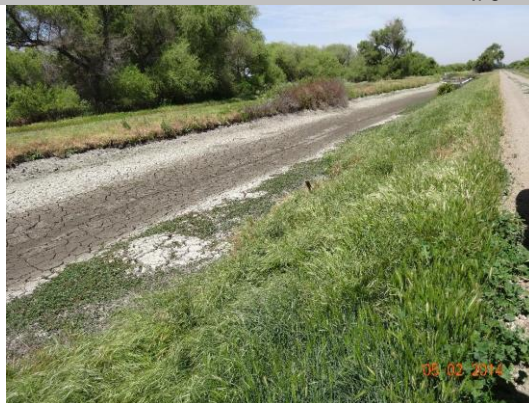
Photo 2 of 3 : UCIP\_SP\_2017\_39370\_66244.jpg

Item	DWR UCIP LMA Responsibility			37.179265 °		37.179265 °
				-120.764870 °		-120.764870 °
DWR ID						
Comment Code						
Inspector Comment						
FS_ID:39370						
DS_ID:19663						
EP_NO: N/A						
Repair Type: Non-Urgent						
Crossing Status: Found						
UCIP Comments: Dense vegetation limits the inspector's visibility to identify signs of pipe failure (leaks) along the slope. Recommend removing vegetation along pipe alignment to conduct proper inspection of structure. Sediment buildup in pipe--recommend clearing.						
FIELD_STRUCT_DESC: 24-inch CM pipe through the levee, 6.5 feet below the crown. Slide gate in pipe riser on the waterward slope. (USACE-1967). This entry matches the Drainage or Irrigation Structure referenced in O&M manual (HLM 13.22).						
FS Date: 5/14/2014

Overview of landward slope.

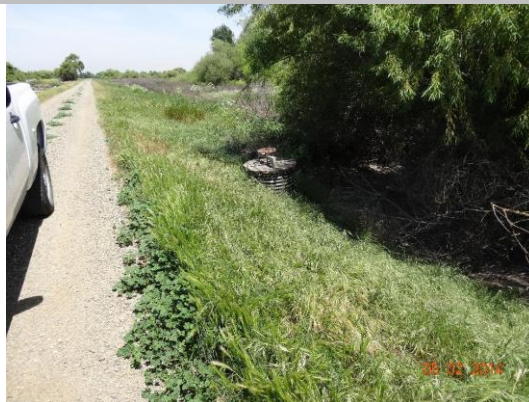
Photo 3 of 3 : UCIP\_SP\_2017\_39370\_66243.jpg

LM Start	<b>13.18</b>	Rating **	M	Issue No.	<b>178 (cont)</b>
LM End	<b>13.18</b>	Issue Type +	Ma	Location *	LS

View of waterward side.

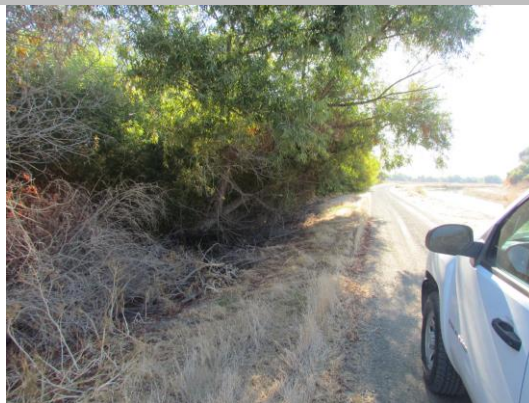
Photo 1 of 1 : SP\_2017\_NA0010\_120\_167\_20170417\_00008.jpg

LM Start	13.42	Rating **	U	Issue No.	167
LM End	13.42	Issue Type +	Ma	Location *	WS
Category	Earthen Levee			GPS Latitude/Longitude	
				Start	End
Item	Trim / Thin Trees			37.176379 °	37.176379 °
				-120.762255 °	-120.762255 °
DWR ID	DWR_NA0010_02B_s_2015_167				
Comment Code					
T3 : Trim and thin trees to allow visibility of the ground and room to flood fight.					
Inspector Comment					
Dense trees on waterward slope.

Looking south at untrimmed trees on waterward slope.

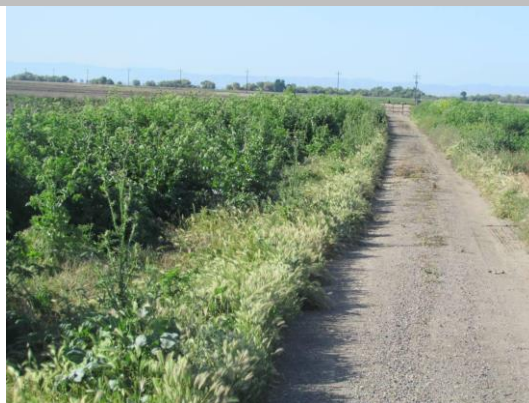
Photo 1 of 1 : SP\_2017\_NA0010\_120\_19\_20170424\_00011.jpg

LM Start	13.64	Rating **	U	Issue No.	19
LM End	13.75	Issue Type +	Ma	Location *	LS
Category	Earthen Levee			GPS Latitude/Longitude	
				Start	End
Item	Vegetation			37.173767 °	37.172157 °
				-120.761018 °	-120.761200 °
DWR ID	DWR_NA0010_02B_s_2017_19				
Comment Code					
V2 : Remove the wild growth other than native grasses from the levee slopes.					
Inspector Comment

Looking northwest at dense veg on landward slope.

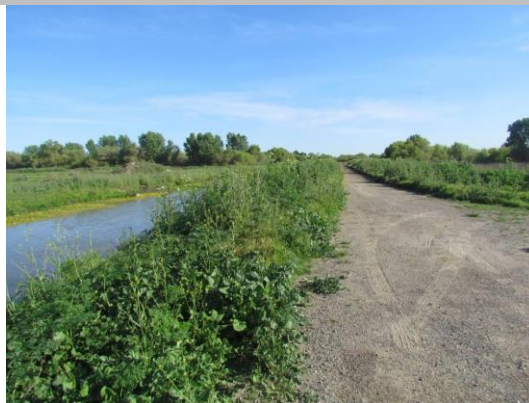
Photo 1 of 1 : SP\_2017\_NA0010\_120\_20\_20170424\_00010.jpg

LM Start	13.64	Rating **	U	Issue No.	20
LM End	13.75	Issue Type +	Ma	Location *	WS
Category	Earthen Levee			GPS Latitude/Longitude	
				Start	End
Item	Vegetation			37.173767 °	37.172157 °
				-120.761018 °	-120.761200 °
DWR ID	DWR_NA0010_02B_s_2017_20				
Comment Code					
V2 : Remove the wild growth other than native grasses from the levee slopes.					
Inspector Comment

Looking downstree at dense veg on waterward slope.

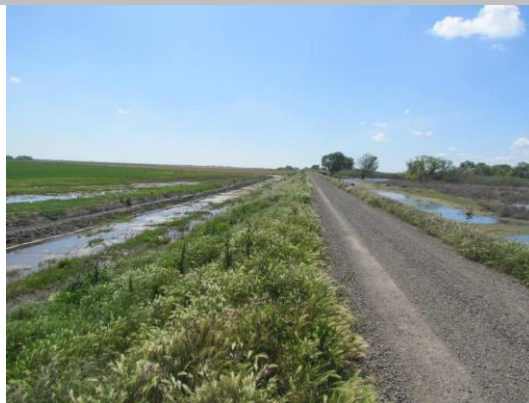
Photo 1 of 1 : SP\_2017\_NA0010\_121\_5\_20170424\_00014.jpg

LM Start	0.00	Rating **	M	Issue No.	5
LM End	2.09	Issue Type +	Ma	Location *	LS
Category	Earthen Levee			GPS Latitude/Longitude	
				Start	End
Item	Vegetation			37.111742 °	37.089017 °
				-120.587550 °	-120.566927 °
DWR ID	DWR_NA0010_03_s_2017_5				
Comment Code					
V1 : Control annual grass and weeds on the levee slopes and easements.					
Inspector Comment

Looking at typical view of landward slope.

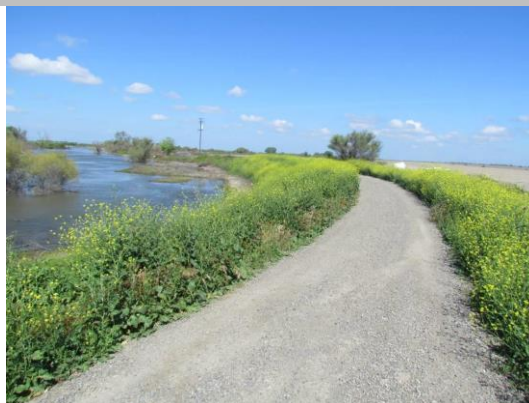
Photo 1 of 1 : SP\_2017\_NA0010\_121\_6\_20170424\_00013.jpg

LM Start	0.00	Rating **	M	Issue No.	6
LM End	2.09	Issue Type +	Ma	Location *	WS
Category	Earthen Levee			GPS Latitude/Longitude	
				Start	End
Item	Vegetation			37.111742 °	37.089017 °
				-120.587550 °	-120.566927 °
DWR ID	DWR_NA0010_03_s_2017_6				
Comment Code					
V1 : Control annual grass and weeds on the levee slopes and easements.					
Inspector Comment

Looking typical view of waterward slope.

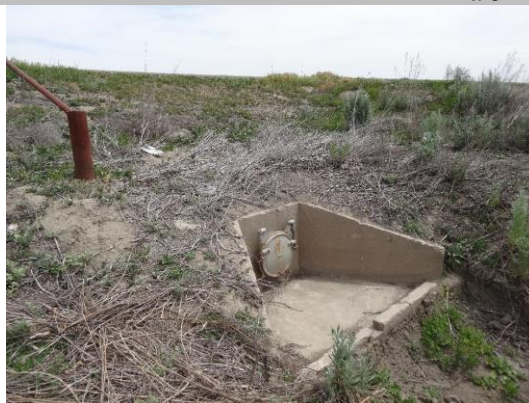
Photo 1 of 3 : UCIP\_SP\_2017\_34083\_61941.jpg

LM Start	0.42	Rating **	M	Issue No.	68
LM End	0.42	Issue Type +	Ma	Location *	LS
Category	Supplemental			GPS Latitude/Longitude	
				Start	End
Item	DWR UCIP LMA Responsibility			37.106233 °	37.106233 °
				-120.585797 °	-120.585797 °
DWR ID					
Comment Code					
Inspector Comment					
FS_ID:34083 DS_ID:19691 EP_NO: N/A Repair Type: Non-Urgent Crossing Status: Found UCIP Comments: Need to contact owner. Recommend removing tall grass on landward slope and clearing sediment build up inside pipe. FIELD_STRUCT_DESC: 24-inch CM pipe through the levee, 11.3 feet below the crown. Flap gate on the waterward end. (USACE-1967). This entry matches the Drainage or Irrigation Structure referenced in O&M manual (HLM 0.43). FS Date: 4/17/2014

Concrete structure and flap gate visible on waterward side.

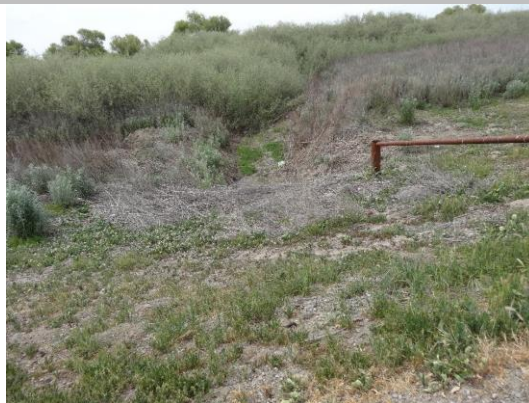
Photo 2 of 3 : UCIP\_SP\_2017\_34083\_61940.jpg

LM Start	<b>0.42</b>	Rating **	M	Issue No.	<b>68 (cont)</b>
LM End	<b>0.42</b>	Issue Type +	Ma	Location *	LS

View of waterward side.

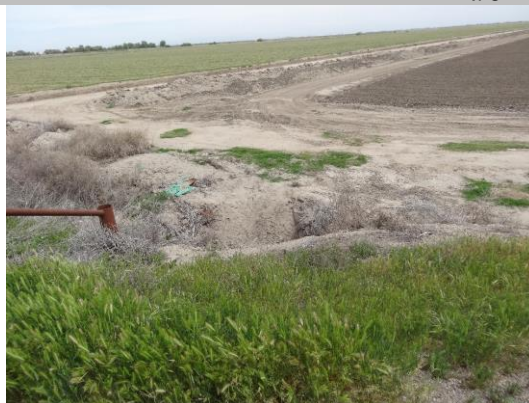
Photo 3 of 3 : UCIP\_SP\_2017\_34083\_61944.jpg

LM Start	0.42	Rating **	M	Issue No.	68 (cont)	
LM End	0.42	Issue Type +	Ma	Location *	LS	
Category	Supplemental			GPS Latitude/Longitude		
				Start	End	
Item	DWR UCIP LMA Responsibility			37.106233 °	37.106233 °	
				-120.585797 °	-120.585797 °	
DWR ID						
Comment Code						
Inspector Comment						
FS_ID:34083						
DS_ID:19691						
EP_NO: N/A						
Repair Type: Non-Urgent						
Crossing Status: Found						
UCIP Comments: Need to contact owner. Recommend removing tall grass on landward slope and clearing sediment build up inside pipe.						
FIELD_STRUCT_DESC: 24-inch CM pipe through the levee, 11.3 feet below the crown. Flap gate on the waterward end. (USACE-1967). This entry matches the Drainage or Irrigation Structure referenced in O&M manual (HLM 0.43).						
FS Date: 4/17/2014

View of landward side.

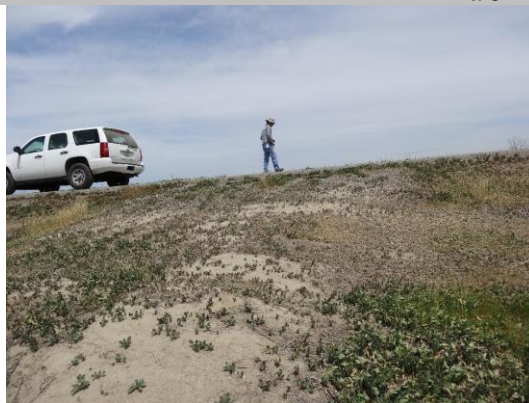
Photo 1 of 3 : UCIP\_SP\_2017\_36534\_66248.jpg

LM Start	0.76	Rating **	A/W	Issue No.	69
LM End	0.76	Issue Type +	Ma	Location *	LS
Category	Supplemental			GPS Latitude/Longitude	
				Start	End
Item	DWR UCIP LMA Responsibility			37.102964 °	37.102964 °
				-120.581421 °	-120.581421 °
DWR ID					
Comment Code					
Inspector Comment					
FS_ID:36534 DS_ID:19692 EP_NO: N/A Repair Type: No Action Needed Crossing Status: Found UCIP Comments: FIELD_STRUCT_DESC: 24-inch CM pipe through the levee, 9.3 feet below the crown. Flap gate on the waterward end. (USACE-1967). This entry matches the Drainage or Irrigation Structure referenced in O&M manual (HLM 0.77). FS Date: 4/17/2014

View of waterward slope.

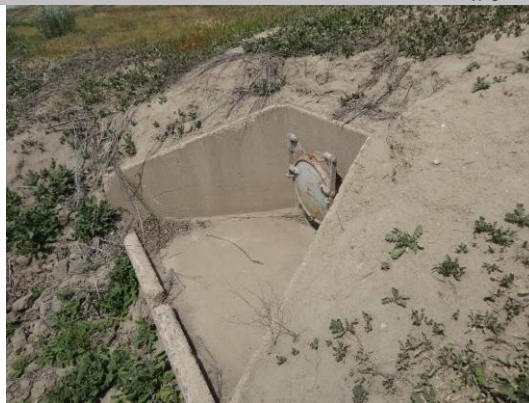
Photo 2 of 3 : UCIP\_SP\_2017\_36534\_66249.jpg

LM Start	0.76	Rating **	A/W	Issue No.	69 (cont)
LM End	0.76	Issue Type +	Ma	Location *	LS
Category	Supplemental			GPS Latitude/Longitude	
				Start	End
Item	DWR UCIP LMA Responsibility			37.102964 °	37.102964 °
				-120.581421 °	-120.581421 °
DWR ID					
Comment Code					
Inspector Comment					
FS_ID:36534					
DS_ID:19692					
EP_NO: N/A					
Repair Type: No Action Needed					
Crossing Status: Found					
UCIP Comments:					
FIELD_STRUCT_DESC: 24-inch CM pipe through the levee, 9.3 feet below the crown. Flap gate on the waterward end. (USACE-1967). This entry matches the Drainage or Irrigation Structure referenced in O&M manual (HLM 0.77).					
FS Date: 4/17/2014

Concrete structure located on waterward side.

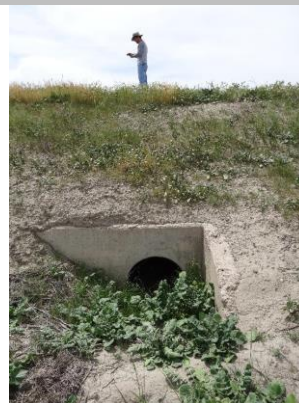
Photo 3 of 3 : UCIP\_SP\_2017\_36534\_66251.jpg

LM Start	<b>0.76</b>	Rating **	A/W	Issue No.	<b>69 (cont)</b>
LM End	<b>0.76</b>	Issue Type +	Ma	Location *	LS

View of landward slope.

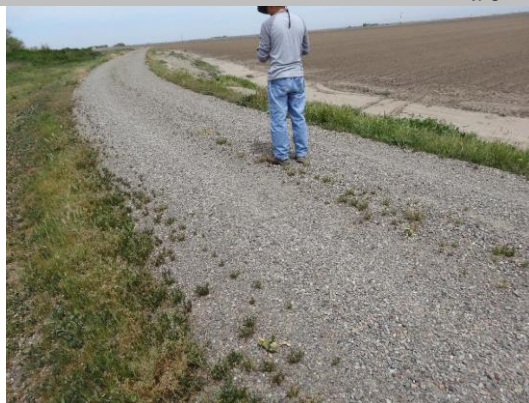
Photo 1 of 3 : UCIP\_SP\_2017\_39371\_66252.jpg

LM Start	<b>1.71</b>	Rating **	M	Issue No.	<b>70</b>
LM End	<b>1.71</b>	Issue Type +	Ma	Location *	LS
Category	Supplemental		GPS Latitude/Longitude		
			Start	End	
Item	DWR UCIP LMA Responsibility		37.092079 °	37.092079 °	
			-120.572316 °	-120.572316 °	
DWR ID					
Comment Code					
Inspector Comment					
FS_ID:39371 DS_ID:19693 EP_NO: N/A Repair Type: Non-Urgent Crossing Status: Found UCIP Comments: Sediment buildup in pipe visible from landward side--recommend clearing. FIELD_STRUCT_DESC: 24-inch CM pipe through the levee, 6.8 feet below the crown. Flap gate on the waterward end. (USACE-1967). This entry matches the Drainage or Irrigation Structure referenced in O&M manual (HLM 1.72). FS Date: 4/17/2014

View of levee crown at crossing.

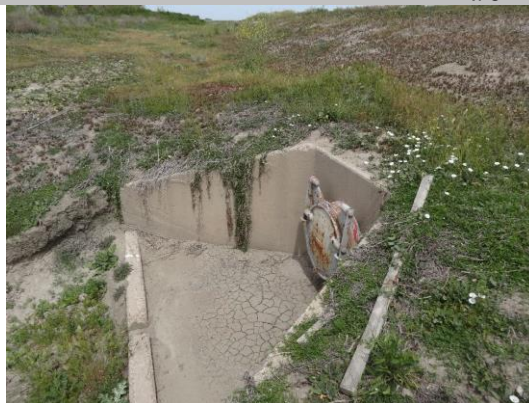
Photo 2 of 3 : UCIP\_SP\_2017\_39371\_66254.jpg

LM Start	1.71	Rating **	M	Issue No.	70 (cont)
LM End	1.71	Issue Type +	Ma	Location *	LS
Category	Supplemental			GPS Latitude/Longitude	
				Start	End
Item	DWR UCIP LMA Responsibility			37.092079 °	37.092079 °
				-120.572316 °	-120.572316 °
DWR ID					
Comment Code					
Inspector Comment					
FS_ID:39371 DS_ID:19693 EP_NO: N/A Repair Type: Non-Urgent Crossing Status: Found UCIP Comments: Sediment buildup in pipe visible from landward side--recommend clearing. FIELD_STRUCT_DESC: 24-inch CM pipe through the levee, 6.8 feet below the crown. Flap gate on the waterward end. (USACE-1967). This entry matches the Drainage or Irrigation Structure referenced in O&M manual (HLM 1.72). FS Date: 4/17/2014

Concrete structure located on waterward side.

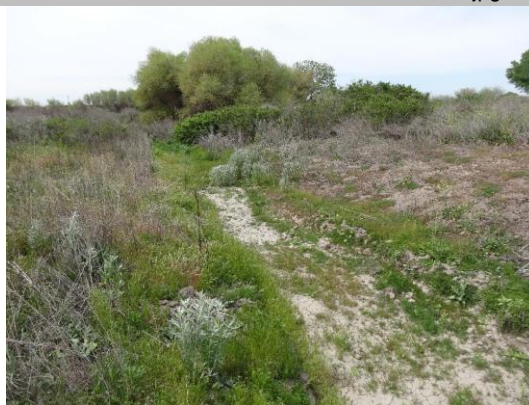
Photo 3 of 3 : UCIP\_SP\_2017\_39371\_66253.jpg

View of waterward side--channel.

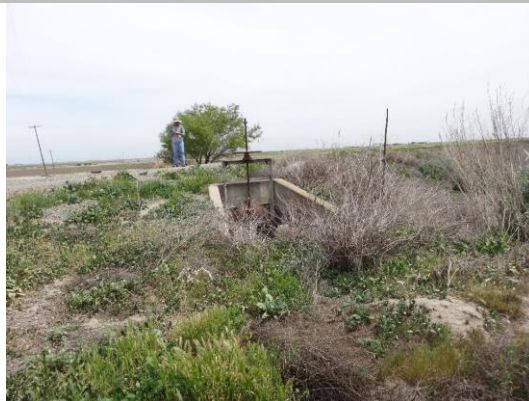
Photo 1 of 3 : UCIP\_SP\_2017\_36543\_66281.jpg

LM Start	2.04	Rating **	M	Issue No.	71
LM End	2.04	Issue Type +	En	Location *	LS
Category	Supplemental			GPS Latitude/Longitude	
				Start	End
Item	DWR UCIP Field Study			37.089394 °	37.089394 °
				-120.567731 °	-120.567731 °
DWR ID					
Comment Code					
Inspector Comment					
FS_ID:36543 DS_ID:19694 EP_NO: N/A Repair Type: Non-Urgent Crossing Status: Found UCIP Comments: Need to contact owner--additional appurtenances found on waterward side not part of original description. Unable to determine if walkway, pump, and pipe through waterward berm is if part of original crossing. FIELD_STRUCT_DESC: 36-inch CM pipe through the levee, 6.6 feet below the crown. Slide gate on the waterward end. Pump on the waterward bank. (USACE-1967). This entry matches the Drainage or Irrigation Structure referenced in O&M manual (HLM 2.05). FS Date: 4/17/2014

Slide gate and concrete structure located on waterward slope.

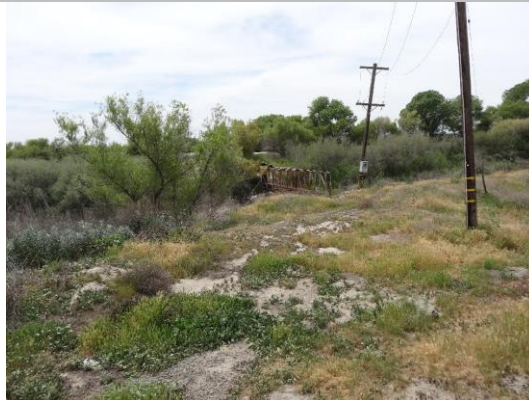
Photo 2 of 3 : UCIP\_SP\_2017\_36543\_66282.jpg

View of walkway and berm on waterward side.

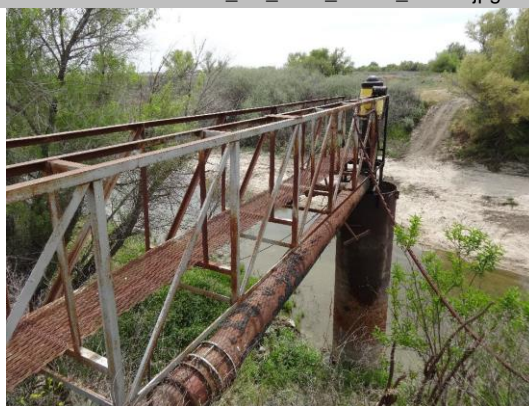
Photo 3 of 3 : UCIP\_SP\_2017\_36543\_66280.jpg

LM Start	2.04	Rating **	M	Issue No.	71 (cont)
LM End	2.04	Issue Type +	En	Location *	LS
Category	Supplemental			GPS Latitude/Longitude	
				Start	End
Item	DWR UCIP Field Study			37.089394 °	37.089394 °
				-120.567731 °	-120.567731 °
DWR ID					
Comment Code					
Inspector Comment					
FS_ID:36543 DS_ID:19694 EP_NO: N/A Repair Type: Non-Urgent Crossing Status: Found UCIP Comments: Need to contact owner--additional appurtenances found on waterward side not part of original description. Unable to determine if walkway, pump, and pipe through waterward berm is if part of original crossing. FIELD_STRUCT_DESC: 36-inch CM pipe through the levee, 6.6 feet below the crown. Slide gate on the waterward end. Pump on the waterward bank. (USACE-1967). This entry matches the Drainage or Irrigation Structure referenced in O&M manual (HLM 2.05). FS Date: 4/17/2014

Pump and damage walkway located on waterward side.

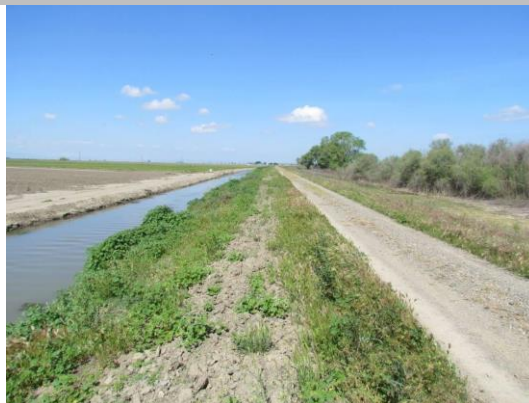
Photo 1 of 1 : SP\_2017\_NA0010\_122\_8\_20170424\_00023.jpg

LM Start	0.00	Rating **	M	Issue No.	8
LM End	1.41	Issue Type +	Ma	Location *	LS
Category	Earthen Levee			GPS Latitude/Longitude	
				Start	End
Item	Vegetation			37.112553 °	37.097573 °
				-120.589085 °	-120.578140 °
DWR ID	DWR_NA0010_04_s_2017_8				
Comment Code					
V1 : Control annual grass and weeds on the levee slopes and easements.					
Inspector Comment

Looking at typical view of landward slope.

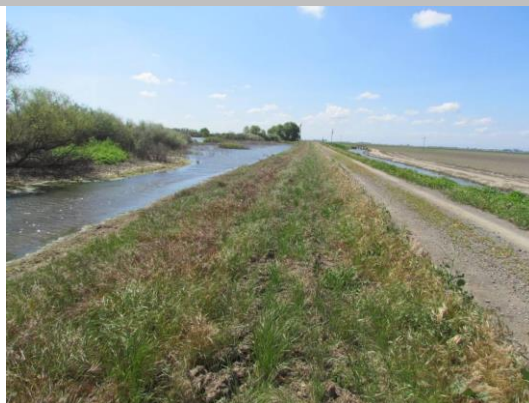
Photo 1 of 1 : SP\_2017\_NA0010\_122\_9\_20170424\_00022.jpg

LM Start	0.00	Rating **	M	Issue No.	9
LM End	1.41	Issue Type +	Ma	Location *	WS
Category	Earthen Levee			GPS Latitude/Longitude	
				Start	End
Item	Vegetation			37.112553 °	37.097573 °
				-120.589085 °	-120.578140 °
DWR ID	DWR_NA0010_04_s_2017_9				
Comment Code					
V1 : Control annual grass and weeds on the levee slopes and easements.					
Inspector Comment

Looking at typical view of waterward slope.

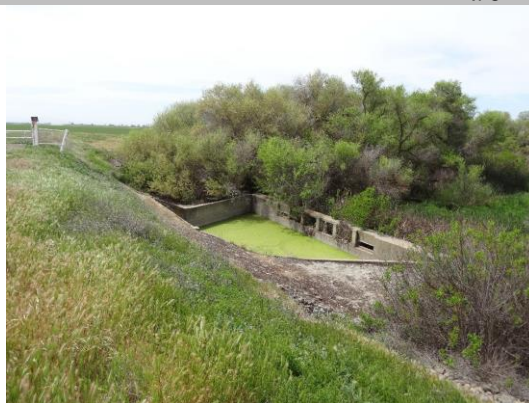
Photo 1 of 3 : UCIP\_SP\_2017\_40529\_61969.jpg

LM Start	0.03	Rating **	M	Issue No.	10
LM End	0.03	Issue Type +	En	Location *	WS
Category	Supplemental			GPS Latitude/Longitude	
				Start	End
Item	DWR UCIP Field Study			37.112353 °	37.112353 °
				-120.589565 °	-120.589565 °
DWR ID					
Comment Code					
Inspector Comment					
FS_ID:40529					
DS_ID:19977					
EP_NO: 5024					
Repair Type: Non-Urgent					
Crossing Status: Found					
UCIP Comments: Slide gates blocked by sediment. Recommend contacting owner to determine status of crossing. Crossing appears to be abandoned.					
FIELD_STRUCT_DESC: [San Joaquin River Diversion Structure] 1 of 4: 72x60-inch R.C.B.C. through the levee, 21.0 feet below the crown. Slide gates on the waterward side. Concrete headwalls on both sides. Landward slope cobble revetted. Flashboards can be seen on the downstream side of the structure.					
FS Date: 4/17/2014

View of concrete structure located on landward side.

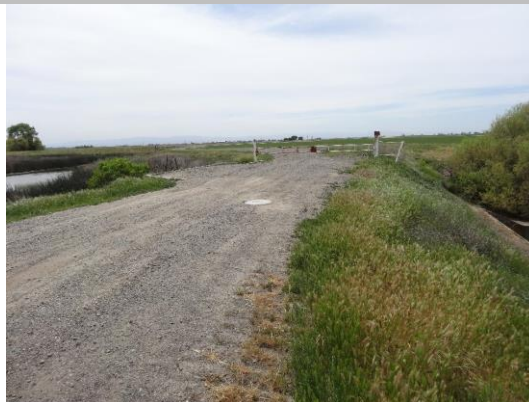
Photo 2 of 3 : UCIP\_SP\_2017\_40529\_61968.jpg

View of levee crown.

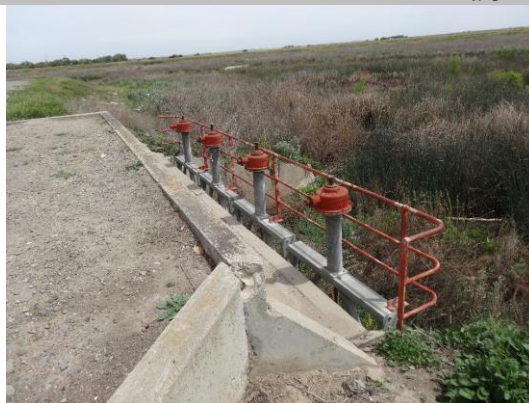
Photo 3 of 3 : UCIP\_SP\_2017\_40529\_61967.jpg

LM Start	0.03	Rating **	M	Issue No.	10 (cont)	
LM End	0.03	Issue Type +	En	Location *	WS	
Category	Supplemental			GPS Latitude/Longitude		
				Start		End
Item	DWR UCIP Field Study			37.112353 °	37.112353 °	
				-120.589565 °	-120.589565 °	
DWR ID						
Comment Code						
Inspector Comment						
FS_ID:40529						
DS_ID:19977						
EP_NO: 5024						
Repair Type: Non-Urgent						
Crossing Status: Found						
UCIP Comments: Slide gates blocked by sediment. Recommend contacting owner to determine status of crossing. Crossing appears to be abandoned.						
FIELD_STRUCT_DESC: [San Joaquin River Diversion Structure] 1 of 4: 72x60-inch R.C.B.C. through the levee, 21.0 feet below the crown. Slide gates on the waterward side. Concrete headwalls on both sides.						
Landward slope cobble revetted. Flashboards can be seen on the downstream side of the structure.						
FS Date: 4/17/2014

Concrete headwall located on waterward side.

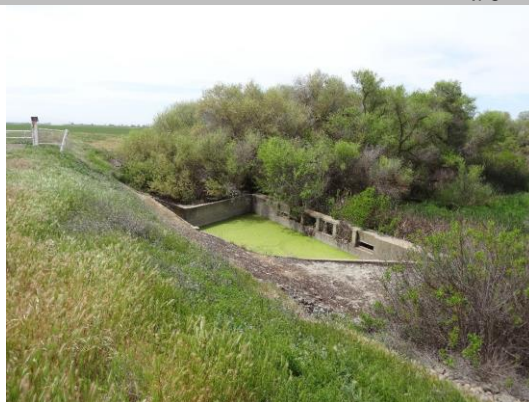
Photo 1 of 3 : UCIP\_SP\_2017\_36875\_67308.jpg

LM Start	0.04	Rating **	M	Issue No.	11
LM End	0.04	Issue Type +	En	Location *	WS
Category	Supplemental			GPS Latitude/Longitude	
				Start	End
Item	DWR UCIP Field Study			37.112348 °	37.112348 °
				-120.589581 °	-120.589581 °
DWR ID					
Comment Code					
Inspector Comment					
FS_ID:36875 DS_ID:24856 EP_NO: 5024 Repair Type: Non-Urgent Crossing Status: Found UCIP Comments: Slide gates blocked by sediment. Recommend contacting owner to determine status of crossing. Crossing appears to be abandoned. FIELD_STRUCT_DESC: [San Joaquin River Diversion Structure] 2 of 4: 72x60-inch R.C.B.C. through the levee, 21.0 feet below the crown. Slide gates on the waterward side. Concrete headwalls on both sides. Landward slope cobble revetted. Flashboards can be seen on the downstream side of the structure. FS Date: 4/17/2014

View of concrete structure located on landward side.
