**Flood Control Project Maintenance  
Levee Inspections**  
**LMA District Cover Sheet**  
**Spring 2017 Levee Inspection Results**

**Lower San Joaquin Levee District**

Waterway			Bank	Unit Miles
Unit No. 01 San Joaquin River			Right	22.52
	Spring (March - May)	Summer (June - August)	(September - November) Fall	Winter (December - February)
Unit Maintenance Rating (Fall Only)				
Date of Inspection	4/17/2017 - 4/20/2017			
DWR Inspector	Richard Willoughby			
Accompanied By

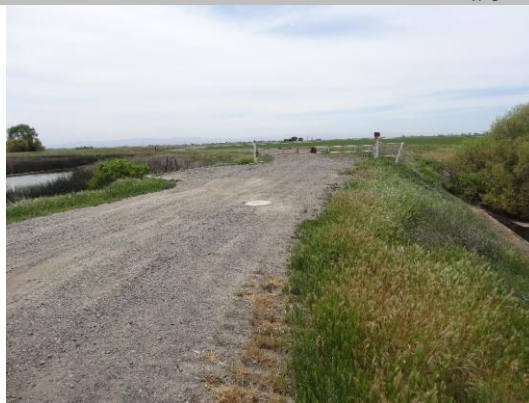
Photo 2 of 3 : UCIP\_SP\_2017\_36875\_67307.jpg

LM Start	0.04	Rating **	M	Issue No.	11 (cont)	
LM End	0.04	Issue Type +	En	Location *	WS	
Category	Supplemental			GPS Latitude/Longitude		
				Start		End
Item	DWR UCIP Field Study			37.112348 °	37.112348 °	
				-120.589581 °	-120.589581 °	
DWR ID						
Comment Code						
Inspector Comment						
FS_ID:36875						
DS_ID:24856						
EP_NO: 5024						
Repair Type: Non-Urgent						
Crossing Status: Found						
UCIP Comments: Slide gates blocked by sediment. Recommend contacting owner to determine status of crossing. Crossing appears to be abandoned.						
FIELD_STRUCT_DESC: [San Joaquin River Diversion Structure] 2 of 4: 72x60-inch R.C.B.C. through the levee, 21.0 feet below the crown. Slide gates on the waterward side. Concrete headwalls on both sides. Landward slope cobble revetted. Flashboards can be seen on the downstream side of the structure.						
FS Date: 4/17/2014

View of levee crown.

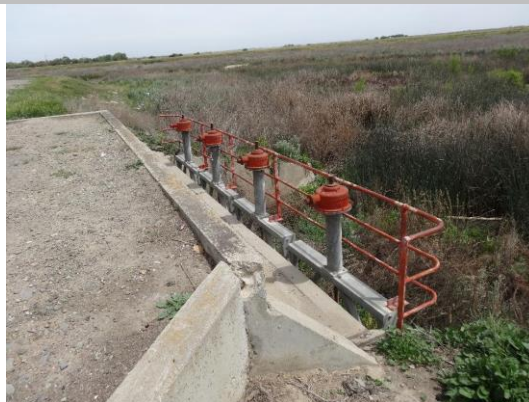
Photo 3 of 3 : UCIP\_SP\_2017\_36875\_67306.jpg

Concrete headwall located on waterward side.

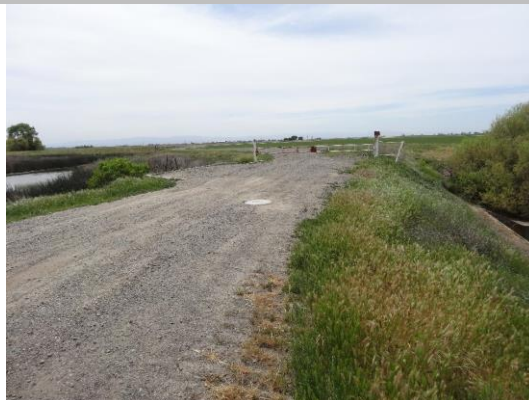
Photo 2 of 3 : UCIP\_SP\_2017\_36876\_67317.jpg

LM Start	0.04	Rating **	M	Issue No.	12
LM End	0.04	Issue Type +	En	Location *	WS
Category	Supplemental			GPS Latitude/Longitude	
				Start	End
Item	DWR UCIP Field Study			37.112343 °	37.112343 °
				-120.589601 °	-120.589601 °
DWR ID					
Comment Code					
Inspector Comment					
FS_ID:36876					
DS_ID:24857					
EP_NO: 5024					
Repair Type: Non-Urgent					
Crossing Status: Found					
UCIP Comments: Slide gates blocked by sediment. Recommend contacting owner to determine status of crossing. Crossing appears to be abandoned.					
FIELD_STRUCT_DESC: [San Joaquin River Diversion Structure] 3 of 4: 72x60-inch R.C.B.C. through the levee, 21.0 feet below the crown. Slide gates on the waterward side. Concrete headwalls on both sides. Landward slope cobble revetted. Flashboards can be seen on the downstream side of the structure.					
FS Date: 4/17/2014

View of levee crown.

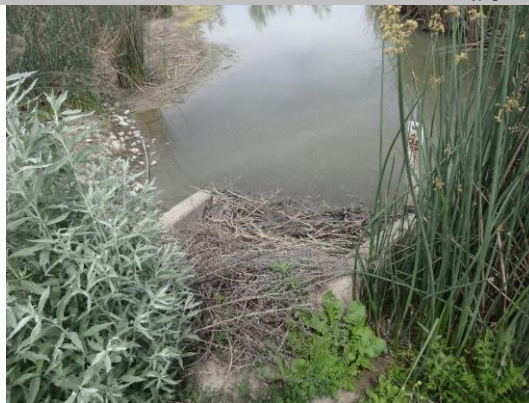
Photo 1 of 3 : UCIP\_SP\_2017\_34093\_61982.jpg

LM Start	0.24	Rating **	M	Issue No.	14
LM End	0.24	Issue Type +	Ma	Location *	WS
Category	Supplemental			GPS Latitude/Longitude	
				Start	End
Item	DWR UCIP LMA Responsibility			37.109933 °	37.109933 °
				-120.590689 °	-120.590689 °
DWR ID					
Comment Code					
Inspector Comment					
FS_ID:34093 DS_ID:19695 EP_NO: N/A Repair Type: Non-Urgent Crossing Status: Found UCIP Comments: Sediment and debris blocking concrete headwall located on waterward side. During inspection water was flowing from landward side to waterward side. Recommend removing sediment to confirm condition of flap gate and pipe. FIELD_STRUCT_DESC: 36-inch CM pipe through the levee, 18.0 feet below the crown. Flap gate on the waterward end. Concrete headwalls on both sides. (USACE-1967). This entry matches the Drainage or Irrigation Structure referenced in O&M manual (HLM 0.27). FS Date: 4/17/2014

View of dense vegetation near concrete headwall located on waterward side.

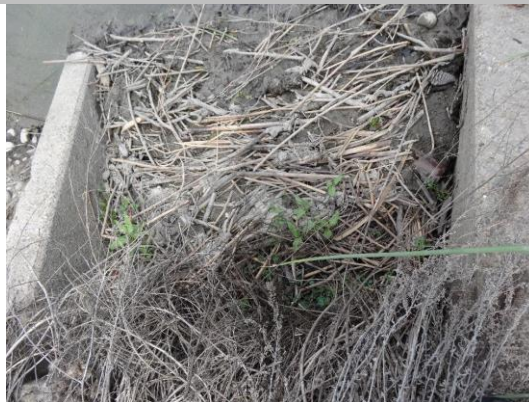
Photo 2 of 3 : UCIP\_SP\_2017\_34093\_61981.jpg

Sediment blocking flap gate located on waterward side.

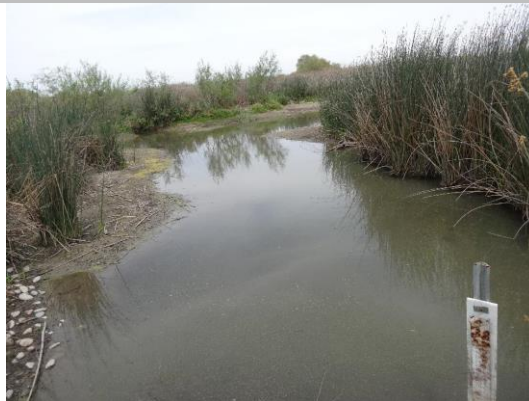
Photo 3 of 3 : UCIP\_SP\_2017\_34093\_61980.jpg

LM Start	0.24	Rating **	M	Issue No.	14 (cont)	
LM End	0.24	Issue Type +	Ma	Location *	WS	
Category	Supplemental			GPS Latitude/Longitude		
				Start		End
Item	DWR UCIP LMA Responsibility			37.109933 °	37.109933 °	
				-120.590689 °	-120.590689 °	
DWR ID						
Comment Code						
Inspector Comment						
FS_ID:34093 DS_ID:19695 EP_NO: N/A Repair Type: Non-Urgent Crossing Status: Found UCIP Comments: Sediment and debris blocking concrete headwall located on waterward side. During inspection water was flowing from landward side to waterward side. Recommend removing sediment to confirm condition of flap gate and pipe. FIELD_STRUCT_DESC: 36-inch CM pipe through the levee, 18.0 feet below the crown. Flap gate on the waterward end. Concrete headwalls on both sides. (USACE-1967). This entry matches the Drainage or Irrigation Structure referenced in O&M manual (HLM 0.27). FS Date: 4/17/2014

View of waterward side.

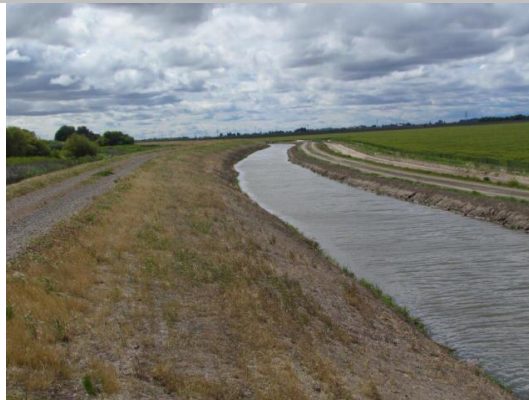
Photo 1 of 3 : SP\_2017\_NA0010\_122\_3\_20170417\_00001.jpg

LM Start	0.32	Rating **	M	Issue No.	3
LM End	1.41	Issue Type +	En	Location *	LS
Category	Earthen Levee			GPS Latitude/Longitude	
				Start	End
Item	Encroachments			37.108822 °	37.097556 °
				-120.590718 °	-120.578130 °
DWR ID	DWR_NA0010_04_s_2012_3				
Comment Code					
DT : Ditch					
Inspector Comment					
Agricultural ditch within 10' easement.

Looking north at irrigation ditch at landside toe.

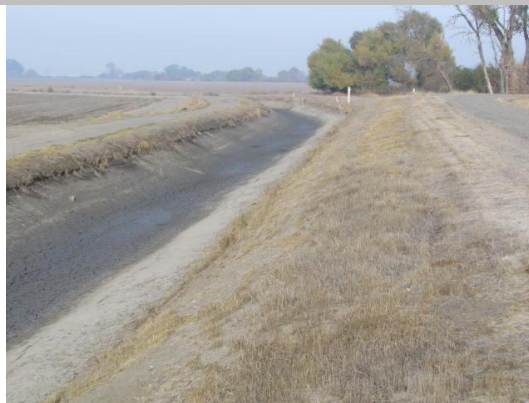
Photo 2 of 3 : SP\_2017\_NA0010\_122\_3\_20170417\_00002.jpg

Looking north at irrigation ditch at landward toe. (Fall 2013)

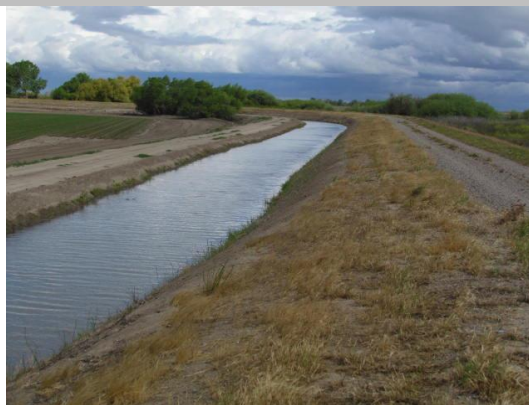
Photo 3 of 3 : SP\_2017\_NA0010\_122\_3\_20170417\_00003.jpg

Looking north at irrigation ditch at landside toe.

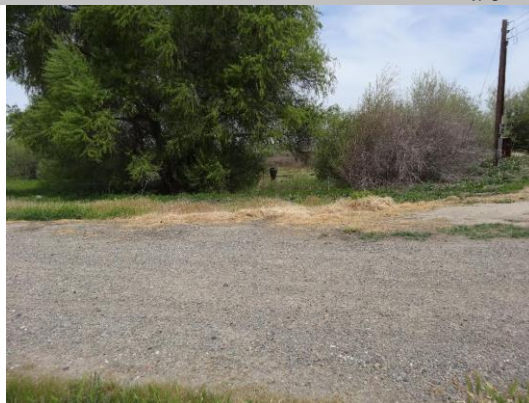
Photo 1 of 3 : UCIP\_SP\_2017\_40530\_61987.jpg

LM Start	1.34	Rating **	M	Issue No.	15
LM End	1.34	Issue Type +	En	Location *	LS
Category	Supplemental			GPS Latitude/Longitude	
				Start	End
Item	DWR UCIP Field Study			37.095274 °	37.095274 °
				-120.577959 °	-120.577959 °
DWR ID					
Comment Code					
Inspector Comment					
FS_ID:40530					
DS_ID:19975					
EP_NO: 3416					
Repair Type: Non-Urgent					
Crossing Status: Found					
UCIP Comments: Unable to confirm if crossing is still in use. Need to contact owner to confirm status.					
FIELD_STRUCT_DESC: 12-inch steel irrigation pipe, encased in 6-inches of reinforced concrete through the levee. Concrete cutoff wall at center of levee. Pumping plant on the waterward bank. Pump and irrigation pipe retained under Permit No. 3416 (1964).					
FS Date: 4/17/2014

View of waterward side.

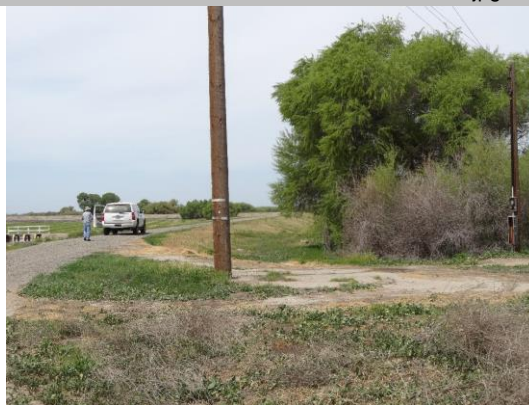
Photo 2 of 3 : UCIP\_SP\_2017\_40530\_61988.jpg

Overview of waterward side and levee crown at crossing.

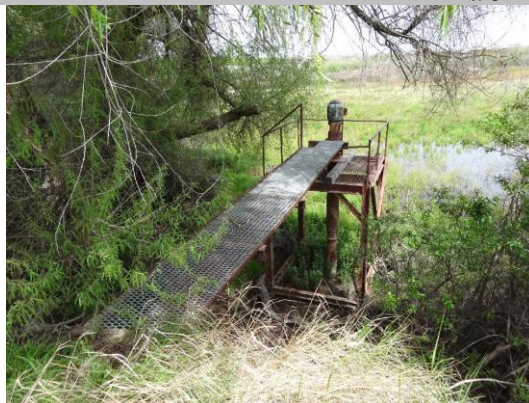
Photo 3 of 3 : UCIP\_SP\_2017\_40530\_61986.jpg

LM Start	1.34	Rating **	M	Issue No.	15 (cont)	
LM End	1.34	Issue Type +	En	Location *	LS	
Category	Supplemental			GPS Latitude/Longitude		
				Start	End	
Item	DWR UCIP Field Study			37.095274 °	37.095274 °	
				-120.577959 °	-120.577959 °	
DWR ID						
Comment Code						
Inspector Comment						
FS_ID:40530						
DS_ID:19975						
EP_NO: 3416						
Repair Type: Non-Urgent						
Crossing Status: Found						
UCIP Comments: Unable to confirm if crossing is still in use. Need to contact owner to confirm status.						
FIELD_STRUCT_DESC: 12-inch steel irrigation pipe, encased in 6-inches of reinforced concrete through the levee. Concrete cutoff wall at center of levee. Pumping plant on the waterward bank. Pump and irrigation pipe retained under Permit No. 3416 (1964).						
FS Date: 4/17/2014

Pump and walkway located on waterward side.

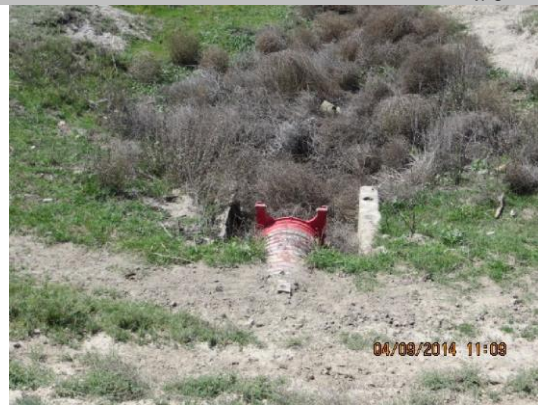
Photo 1 of 3 : UCIP\_SP\_2017\_39563\_60921.jpg

LM Start	0.08	Rating **	M	Issue No.	1311
LM End	0.08	Issue Type +	Ma	Location *	WS
Category	Supplemental			GPS Latitude/Longitude	
				Start	End
Item	DWR UCIP LMA Responsibility			37.278174 °	37.278174 °
				-120.823465 °	-120.823465 °
DWR ID					
Comment Code					
Inspector Comment					
FS_ID:39563 DS_ID:19756 EP_NO: N/A Repair Type: Non-Urgent Crossing Status: Found UCIP Comments: Debris blocking landward headwall--recommend clearing. FIELD_STRUCT_DESC: 24-inch C.M. stormdrain pipe through the levee, 8.6 feet below the crown. Flap gate on the waterward end. Concrete headwall on the landward end. Concrete "U" headwall on the waterward end. (USACE-1967). This entry matches the Drainage or Irrigation Structure referenced in O&M manual (HLM 0.07). FS Date: 4/9/2014

Pipe, flapgate, and concrete headwall on WS toe.

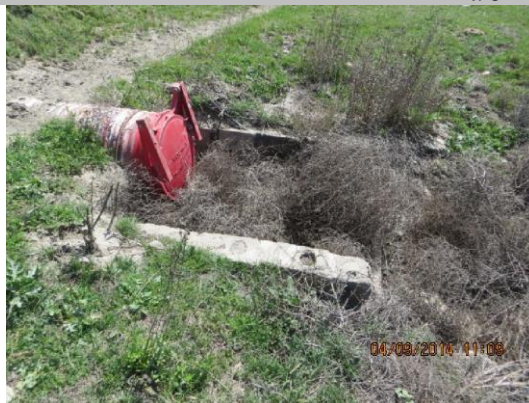
Photo 2 of 3 : UCIP\_SP\_2017\_39563\_60920.jpg

LM Start	0.08	Rating **	M	Issue No.	1311 (cont)
LM End	0.08	Issue Type +	Ma	Location *	WS
Category	Supplemental			GPS Latitude/Longitude	
				Start	End
Item	DWR UCIP LMA Responsibility			37.278174 °	37.278174 °
				-120.823465 °	-120.823465 °
DWR ID					
Comment Code					
Inspector Comment					
FS_ID:39563 DS_ID:19756 EP_NO: N/A Repair Type: Non-Urgent Crossing Status: Found UCIP Comments: Debris blocking landward headwall--recommend clearing. FIELD_STRUCT_DESC: 24-inch C.M. stormdrain pipe through the levee, 8.6 feet below the crown. Flap gate on the waterward end. Concrete headwall on the landward end. Concrete "U" headwall on the waterward end. (USACE-1967). This entry matches the Drainage or Irrigation Structure referenced in O&M manual (HLM 0.07). FS Date: 4/9/2014

Pipe, flapgate, and concrete headwall on WS toe.

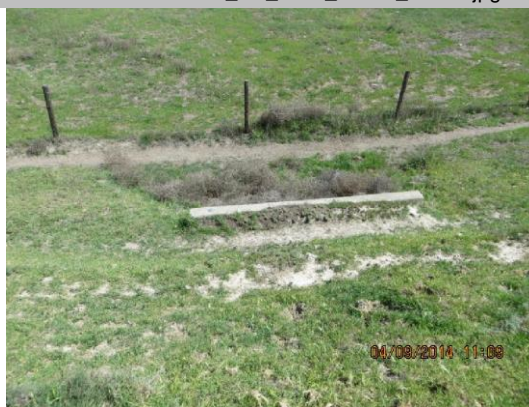
Photo 3 of 3 : UCIP\_SP\_2017\_39563\_60922.jpg

Pipe and concrete headwall on LS toe.

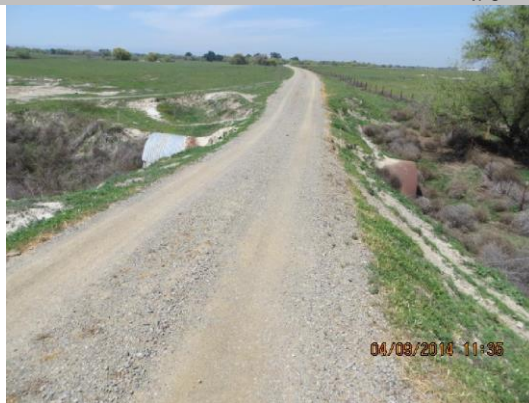
Photo 1 of 3 : UCIP\_SP\_2017\_49967\_71469.jpg

Comment Code					
Inspector Comment					
FS_ID:49967 DS_ID:24867 EP_NO: N/A Repair Type: Urgent Crossing Status: Found UCIP Comments: 07/20/2016 same as previous inspection. Levee section at crossing has been degraded. According to LMA representative, Rick, the low point at crossing has been present for over 10 years when the pipe was replaced. (DWR UCIP - omagana)04/09/2014 Pipe is open on both ends and levee has been degraded at this location. No permit identified for this crossing. (DWR UCIP - omagana) FIELD_STRUCT_DESC: 96-inch corrugated metal drainage pipe through the levee, 4.5 feet below the crown. Pipe is composed of two materials, corrugated metal pipe (CMP) on the WS and steel pipe on the LS. This section of the levee is a degraded section that drops approximately 4 feet within 100 feet in lengh. This section of the levee is the site of the 1960's levee breach. [Additional Reference(s): USACE Periodic Inspection Report 2014, USACE_CESPK_L05A_2014_p_0014] FS Date: 7/20/2016

Pipe through levee where levee has been degraded.

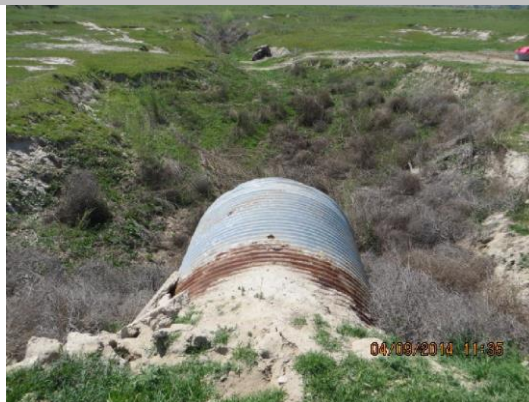
Photo 2 of 3 : UCIP\_SP\_2017\_49967\_71467.jpg

Pipe on WS toe.

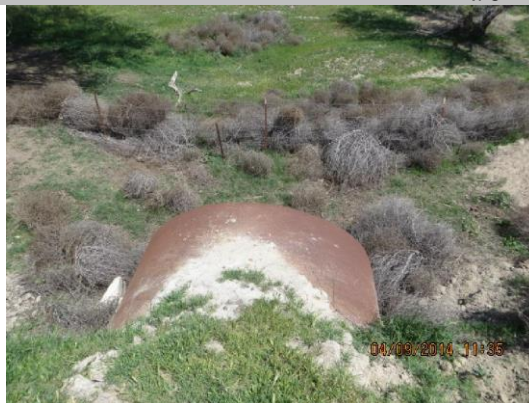
Photo 3 of 3 : UCIP\_SP\_2017\_49967\_71468.jpg

Pipe on LS toe.

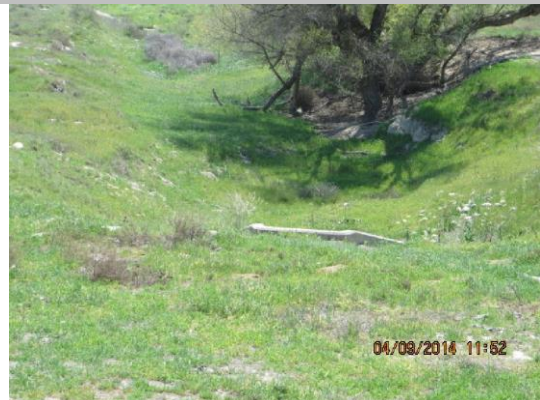
Photo 1 of 3 : UCIP\_SP\_2017\_39585\_60931.jpg

Comment Code					
Inspector Comment					
FS_ID:39585 DS_ID:19758 EP_NO: N/A Repair Type: Non-Urgent Crossing Status: Found UCIP Comments: Dense vegetation limits the inspector's visibility to identify signs of pipe failure (leaks) along the landward slope. Recommend removing vegetation along pipe alignment to conduct proper inspection of structure. FIELD_STRUCT_DESC: 36-inch C.M. stormdrain pipe through the levee, 13.2 feet below the crown. Flap gate on the waterward end. Concrete headwall on the landward end. Concrete "U" headwall on the waterward end. Cobble revetment around both ends. (USACE-1967). This entry matches the Drainage or Irrigation Structure referenced in O&M manual (HLM 0.65). FS Date: 4/9/2014

Concrete headwall visible off WS toe.

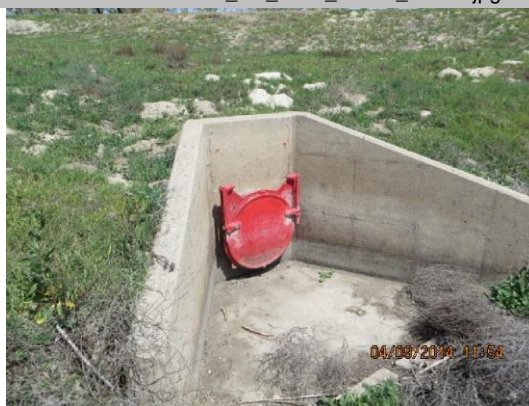
Photo 2 of 3 : UCIP\_SP\_2017\_39585\_60929.jpg

Pipe, flapgate, and headwall at WS toe.

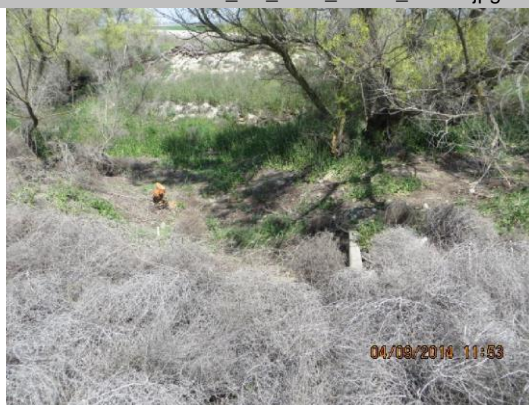
Photo 3 of 3 : UCIP\_SP\_2017\_39585\_60930.jpg

Concrete headwall at LS toe.

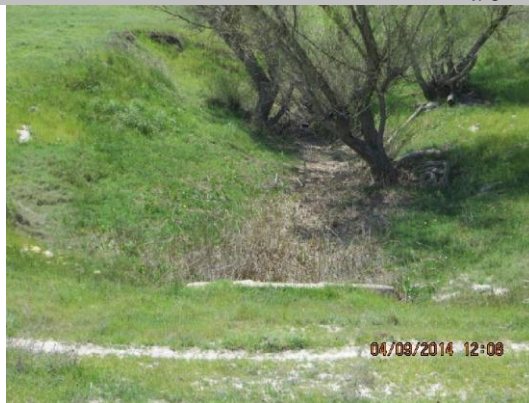
Photo 1 of 3 : UCIP\_SP\_2017\_33707\_60934.jpg

LM Start	0.85	Rating **	A/W	Issue No.	1315
LM End	0.85	Issue Type +	Ma	Location *	WS
Category	Supplemental			GPS Latitude/Longitude	
				Start	End
Item	DWR UCIP LMA Responsibility			37.271894 °	37.271894 °
				-120.812224 °	-120.812224 °
DWR ID					
Comment Code					
Inspector Comment					
FS_ID:33707					
DS_ID:19759					
EP_NO: N/A					
Repair Type: No Action Needed					
Crossing Status: Found					
UCIP Comments:					
FIELD_STRUCT_DESC: 24-inch C.M. stormdrain pipe through the					
levee, 14.4 feet below the crown. Flap gate on the waterward end.					
Concrete headwall on the landward end. Concrete "U" headwall on the					
waterward end. (USACE-1967). This entry matches the Drainage or					
Irrigation Structure referenced in O&M manual (HLM 0.84).					
FS Date: 4/9/2014

Concrete headwall visible at LS toe.

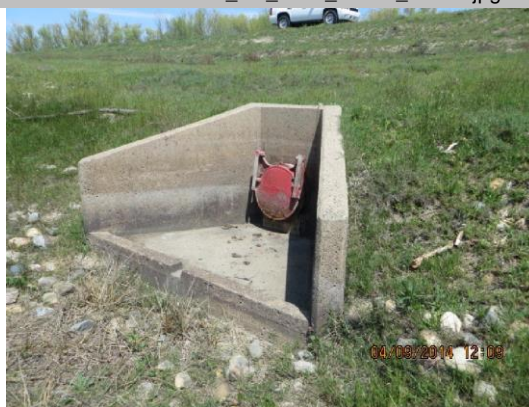
Photo 2 of 3 : UCIP\_SP\_2017\_33707\_60933.jpg

Pipe, flapgate, and headwall at WS toe.

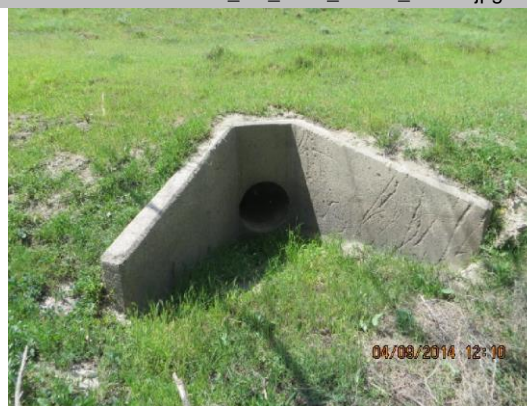
Photo 3 of 3 : UCIP\_SP\_2017\_33707\_60936.jpg

Pipe and concrete headwall at LS toe.

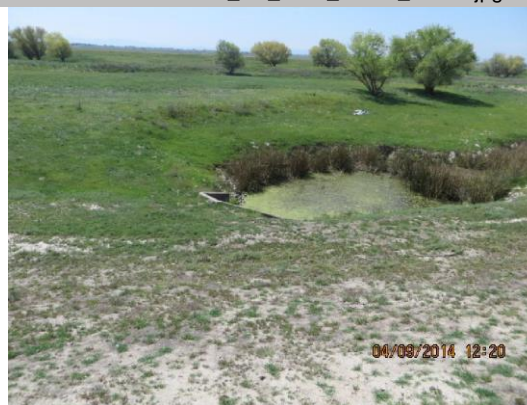
Photo 1 of 3 : UCIP\_SP\_2017\_33708\_60939.jpg

LM Start	1.45	Rating **	A/W	Issue No.	1316
LM End	1.45	Issue Type +	Ma	Location *	WS
Category	Supplemental			GPS Latitude/Longitude	
				Start	End
Item	DWR UCIP LMA Responsibility			37.265804 °	37.265804 °
				-120.804955 °	-120.804955 °
DWR ID					
Comment Code					
Inspector Comment					
FS_ID:33708					
DS_ID:19760					
EP_NO: N/A					
Repair Type: No Action Needed					
Crossing Status: Found					
UCIP Comments:					
FIELD_STRUCT_DESC: 36-inch C.M. stormdrain pipe through the levee, 21.0 feet below the crown. Flap gate on the waterward end. Concrete headwall on the landward end. Concrete "U" headwall on the waterward end. (USACE-1967). This entry matches the Drainage or Irrigation Structure referenced in O&M manual (HLM 1.44).					
FS Date: 4/9/2014

Flapgate on concrete headwall at WS toe.

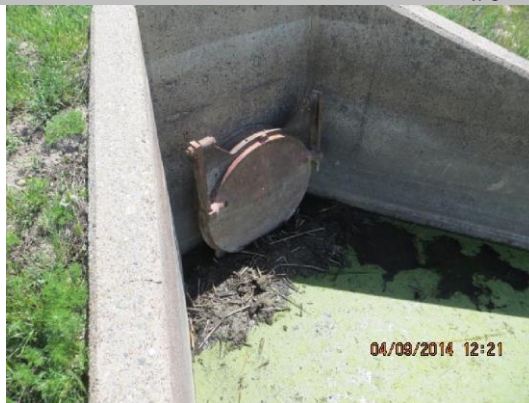
Photo 2 of 3 : UCIP\_SP\_2017\_33708\_60938.jpg

Flapgate on concrete headwall at WS toe.

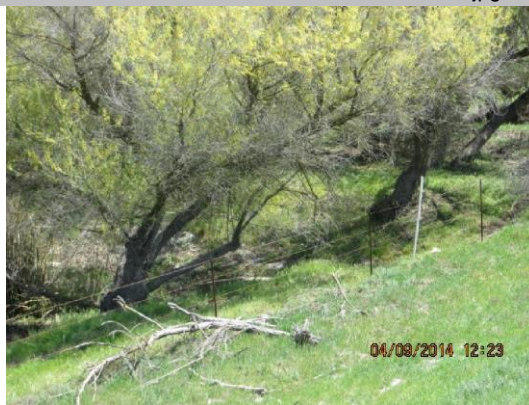
Photo 3 of 3 : UCIP\_SP\_2017\_33708\_60937.jpg

Pipe and concrete headwall on LS toe.

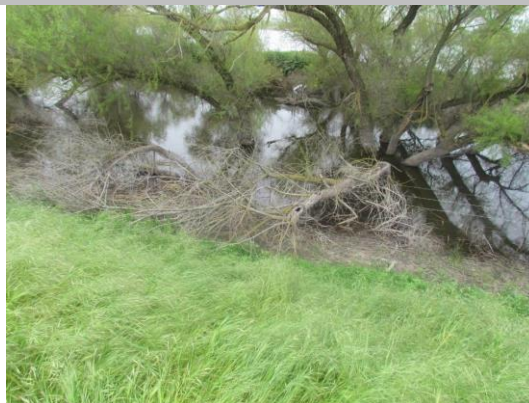
Photo 1 of 1 : SP\_2017\_NA0010\_123\_103\_20170424\_00283.jpg

LM Start	1.48	Rating **	M	Issue No.	103
LM End	1.48	Issue Type +	Ma	Location *	LS
Category	Earthen Levee			GPS Latitude/Longitude	
				Start	End
Item	Encroachments			37.265507 °	37.265507 °
				-120.804688 °	-120.804688 °
DWR ID	DWR_NA0010_05_s_2017_103				
Comment Code					
TR : Tree or limb					
Inspector Comment					
Fallen tree on landward toe.

Looking east at fallen tree at landward toe.

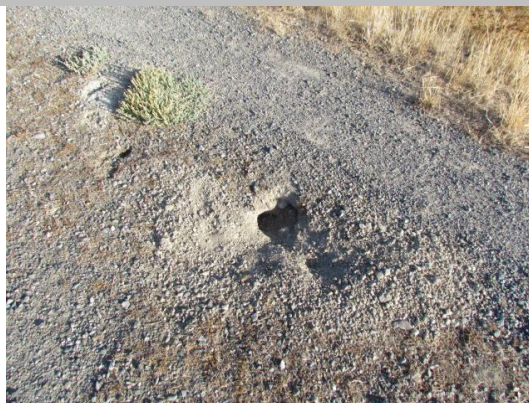
Photo 1 of 1 : SP\_2017\_NA0010\_123\_80\_20170417\_00010.jpg

LM Start	1.66	Rating **	M	Issue No.	80
LM End	1.75	Issue Type +	Ma	Location *	LS
Category	Earthen Levee			GPS Latitude/Longitude	
				Start	End
Item	Animal Control			37.263448 °	37.262225 °
				-120.802715 °	-120.802296 °
DWR ID	DWR_NA0010_05_f_2015_80				
Comment Code					
A3 : No rodents visible, but rodent burrows visible; need to backfill and compact or grout burrows.					
Inspector Comment					
Several rodent holes on levee crown within this section.

Looking at typical view of rodent holes within this section on landward slope.

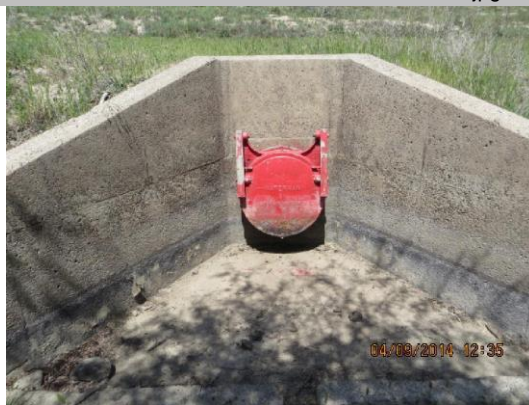
Photo 2 of 3 : UCIP\_SP\_2017\_33709\_60941.jpg

Headwall, pipe, and flapgate on WS toe.

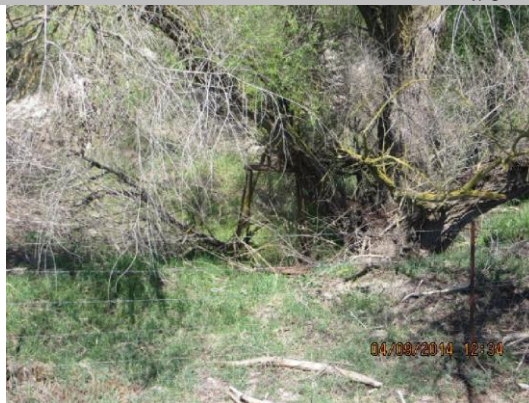
Photo 3 of 3 : UCIP\_SP\_2017\_33709\_60942.jpg

Concrete headwall and metal gate hoist on LS toe.

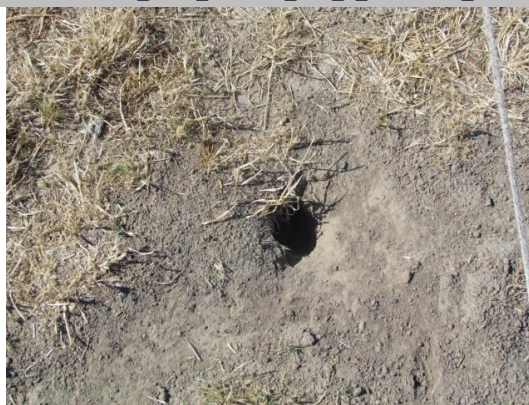
Photo 1 of 1 : SP\_2017\_NA0010\_123\_6\_20170417\_00002.jpg

LM Start	3.20	Rating **	M	Issue No.	6
LM End	3.35	Issue Type +	Ma	Location *	WS
Category	Earthen Levee			GPS Latitude/Longitude	
				Start	End
Item	Animal Control			37.256635 °	37.255170 °
				-120.778935 °	-120.776882 °
DWR ID	DWR_NA0010_05_s_2014_6				
Comment Code					
A1 : Exterminate rodents and backfill and compact or grout burrows.					
Inspector Comment					
No rodent visible but several rodent holes visible on levee crown.

Looking at typical view of rodent holes on waterward slope.

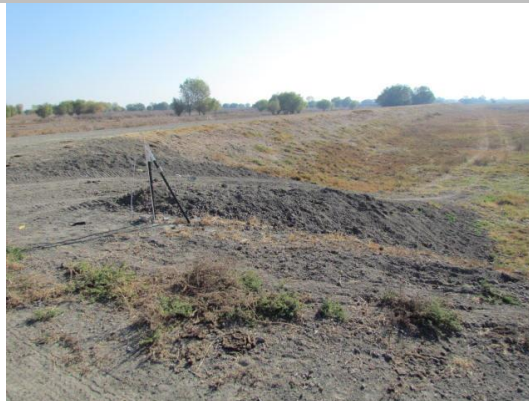
Photo 1 of 3 : SP\_2017\_NA0010\_123\_7\_20170417\_00003.jpg

LM Start	3.20	Rating **	M	Issue No.	7
LM End	3.20	Issue Type +	En	Location *	WS
Category	Earthen Levee			GPS Latitude/Longitude	
				Start	End
Item	Encroachments			37.256554 °	37.256554 °
				-120.778847 °	-120.778847 °
DWR ID	DWR_NA0010_05_f_2012_7				
Comment Code					
RA : Ramp					
Inspector Comment					
Unauthorized ramp on waterside slope.

Looking south at unauthorized ramp on waterside slope.

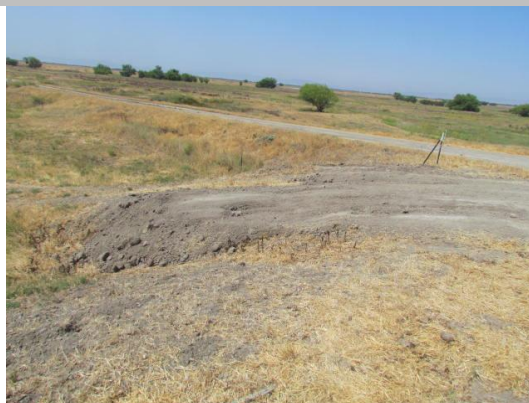
Photo 2 of 3 : SP\_2017\_NA0010\_123\_7\_20170417\_00004.jpg

Looking northwest at unauthorized ramp on waterward slope.

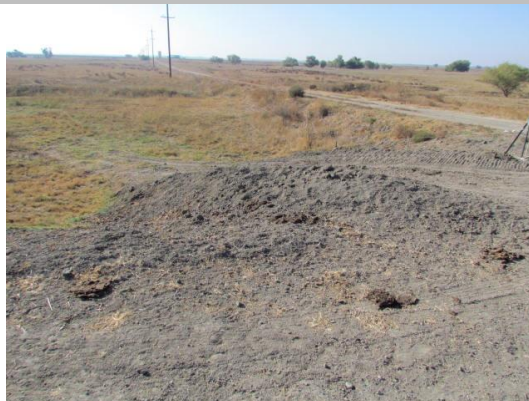
Photo 3 of 3 : SP\_2017\_NA0010\_123\_7\_20170417\_00005.jpg

Looking northwest at unauthorized ramp on waterside slope.

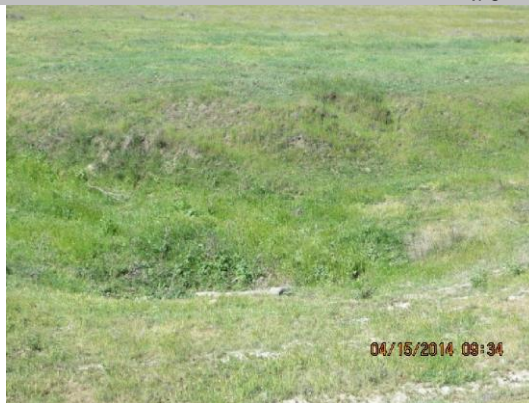
Photo 1 of 3 : UCIP\_SP\_2017\_43055\_60948.jpg

LM Start	3.34	Rating **	M	Issue No.	1318
LM End	3.34	Issue Type +	Ma	Location *	WS
Category	Supplemental			GPS Latitude/Longitude	
				Start	End
Item	DWR UCIP LMA Responsibility			37.255258 °	37.255258 °
				-120.776996 °	-120.776996 °
DWR ID					
Comment Code					
Inspector Comment					
FS_ID:43055					
DS_ID:19810					
EP_NO: N/A					
Repair Type: Non-Urgent					
Crossing Status: Found					
UCIP Comments: Pipe corroded through at flapgate on WS toe.					
FIELD_STRUCT_DESC: 24-inch C.M. stormdrain pipe through the					
levee, 14.7 feet below the crown. Flap gate on the waterward end.					
Concrete "U" headwalls on both ends. (USACE-1967). This entry					
matches the Drainage or Irrigation Structure referenced in O&M manual					
(HLM 3.33).					
FS Date: 4/15/2014

Concrete headwall at WS toe.

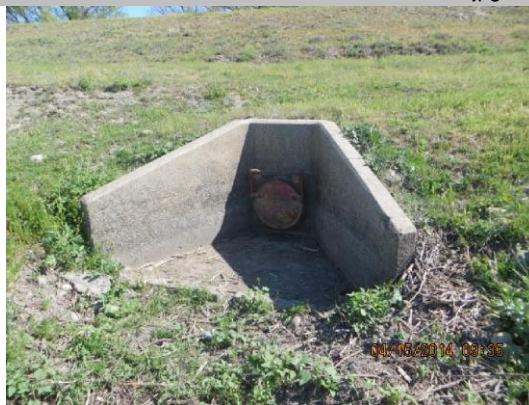
Photo 2 of 3 : UCIP\_SP\_2017\_43055\_60946.jpg

Flapgate and Concrete headwall at WS toe.

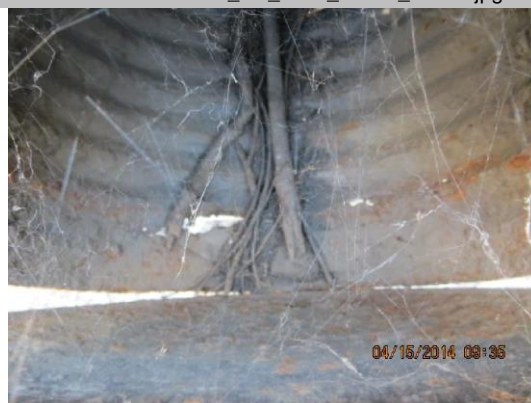
Photo 3 of 3 : UCIP\_SP\_2017\_43055\_60951.jpg

Pipe corroded through just behind flapgate at WS toe.

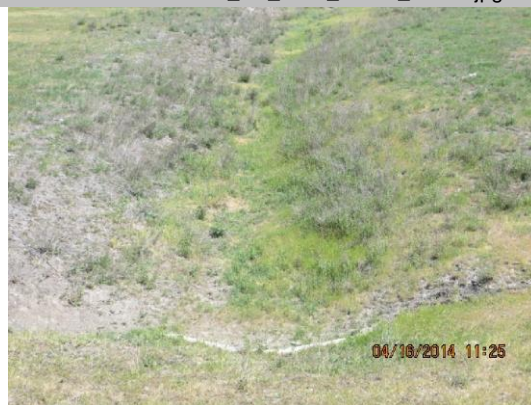
Photo 1 of 3 : UCIP\_SP\_2017\_39586\_61137.jpg

LM Start	3.68	Rating **	M	Issue No.	1319
LM End	3.68	Issue Type +	Ma	Location *	WS
Category	Supplemental			GPS Latitude/Longitude	
				Start	End
Item	DWR UCIP LMA Responsibility			37.252308 °	37.252308 °
				-120.768038 °	-120.768038 °
DWR ID					
Comment Code					
Inspector Comment					
FS_ID:39586 DS_ID:19811 EP_NO: N/A Repair Type: Non-Urgent Crossing Status: Found UCIP Comments: Sediment buildup in pipe visible from landward side--recommend contacting owner to clear pipe. FIELD_STRUCT_DESC: 24-inch C.M. stormdrain pipe through the levee, 15.0 feet below the crown. Flap gate on the waterward end. Concrete headwall on the landward end. Concrete "U" headwall on the waterward end. (USACE-1967). This entry matches the Drainage or Irrigation Structure referenced in O&M manual (HLM 3.67). FS Date: 4/16/2014

Pipe, headwall, and flapgate on WS toe.

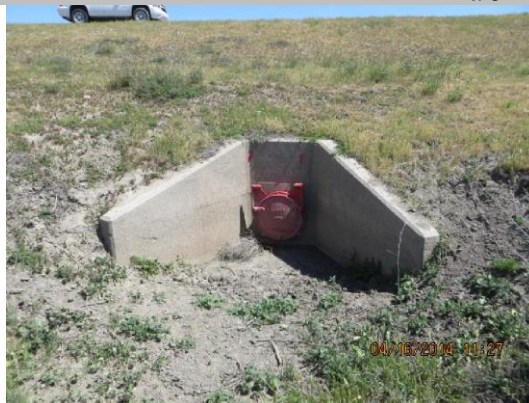
Photo 2 of 3 : UCIP\_SP\_2017\_39586\_61138.jpg

Pipe, headwall, and flapgate on WS toe.

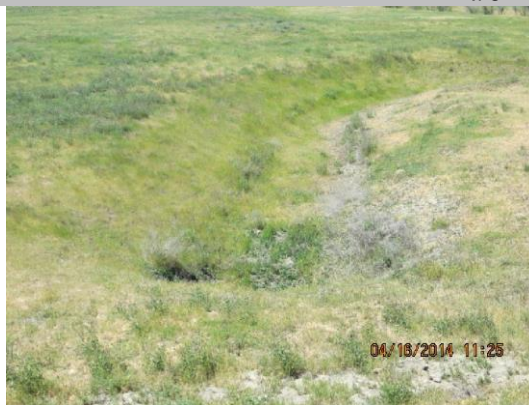
Photo 3 of 3 : UCIP\_SP\_2017\_39586\_61136.jpg

Pipe and headwall on LS toe.

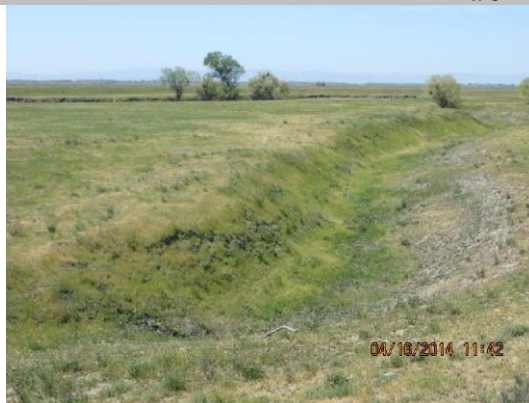
Photo 1 of 3 : UCIP\_SP\_2017\_39880\_61142.jpg

LM Start	4.02	Rating **	M	Issue No.	1320
LM End	4.02	Issue Type +	Ma	Location *	WS
Category	Supplemental			GPS Latitude/Longitude	
				Start	End
Item	DWR UCIP LMA Responsibility			37.248432 °	37.248432 °
				-120.764066 °	-120.764066 °
DWR ID					
Comment Code					
Inspector Comment					
FS_ID:39880 DS_ID:19769 EP_NO: N/A Repair Type: Non-Urgent Crossing Status: Found UCIP Comments: Sediment buildup in pipe visible from landward side--recommend contacting owner to clear pipe. FIELD_STRUCT_DESC: 24-inch C.M. stormdrain pipe through the levee, 16.0 feet below the crown. Flap gate on the waterward end. Concrete "U" headwalls on both ends. (USACE-1967). This entry matches the Drainage or Irrigation Structure referenced in O&M manual (HLM 4.02). FS Date: 4/16/2014

Pipe, headwall, and flapgate on WS toe.

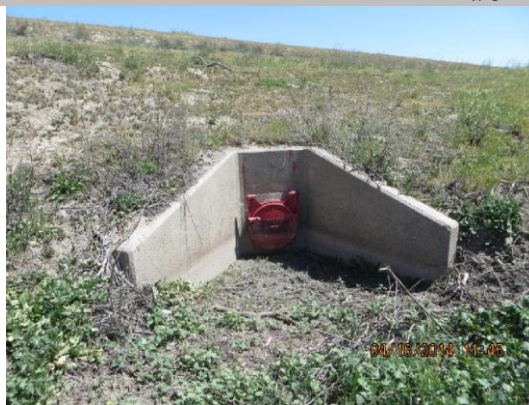
Photo 2 of 3 : UCIP\_SP\_2017\_39880\_61143.jpg

Pipe, headwall, and flapgate on WS toe.

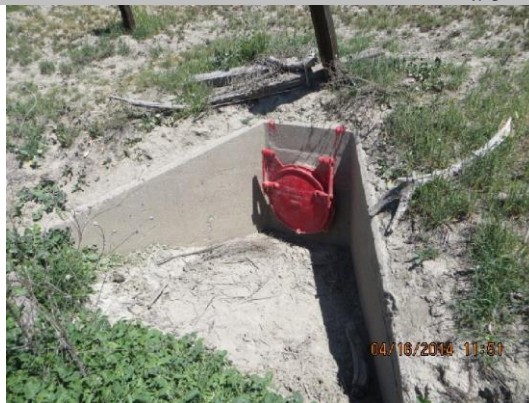
Photo 2 of 3 : UCIP\_SP\_2017\_39588\_61145.jpg

LM Start	4.27	Rating **	M	Issue No.	1321 (cont)	
LM End	4.27	Issue Type +	Ma	Location *	WS	
Category	Supplemental			GPS Latitude/Longitude		
				Start		End
Item	DWR UCIP LMA Responsibility			37.246008 °		37.246008 °
				-120.760706 °		-120.760706 °
DWR ID						
Comment Code						
Inspector Comment						
FS_ID:39588 DS_ID:19770 EP_NO: N/A Repair Type: Non-Urgent Crossing Status: Found UCIP Comments: Sediment buildup in pipe visible from landward side--recommend contacting owner to clear pipe. FIELD_STRUCT_DESC: 24-inch C.M. stormdrain pipe through the levee, 11.6-feet below the crown. Flap gate on the waterward end. Concrete head wall on the landward end. Concrete "U" headwall on the waterward end. (USACE-1967). This entry matches the Drainage or Irrigation Structure referenced in O&M manual (HLM 4.27). FS Date: 4/16/2014

Pipe, headwall, and flapgate on WS toe.

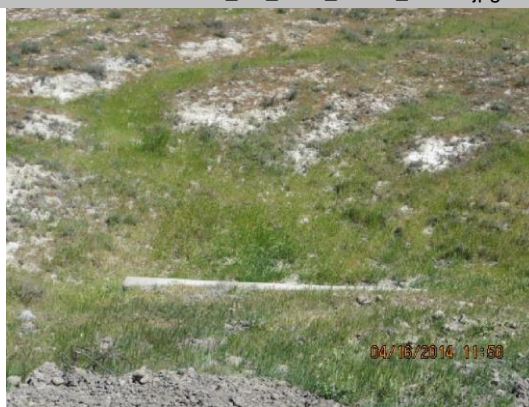
Photo 3 of 3 : UCIP\_SP\_2017\_39588\_61147.jpg

Concrete headwall and pipe on LS toe.

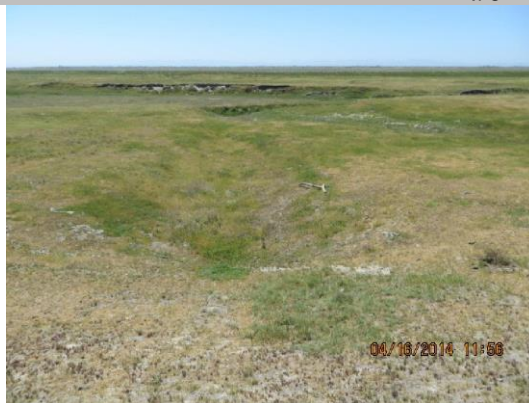
Photo 1 of 3 : UCIP\_SP\_2017\_39589\_62081.jpg

LM Start	4.55	Rating **	M	Issue No.	1322
LM End	4.55	Issue Type +	Ma	Location *	WS
Category	Supplemental			GPS Latitude/Longitude	
				Start	End
Item	DWR UCIP LMA Responsibility			37.243668 °	37.243668 °
				-120.756812 °	-120.756812 °
DWR ID					
Comment Code					
Inspector Comment					
FS_ID:39589 DS_ID:19771 EP_NO: N/A Repair Type: Non-Urgent Crossing Status: Found UCIP Comments: Sediment buildup in pipe visible from landward side--recommend contacting owner to clear pipe. FIELD_STRUCT_DESC: 24-inch C.M. stormdrain pipe through the levee, 12.0-feet below the crown. Flap gate on the waterward end. Concrete headwall on the landward end. Concrete "U" headwall on the waterward end. (USACE-1967). This entry matches the Drainage or Irrigation Structure referenced in O&M manual (HLM 4.54). FS Date: 4/16/2014 8:16:00 AM

Pipe, flapgate, and headwall on WS toe.

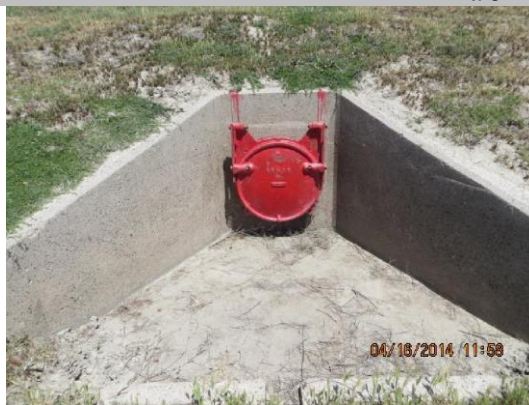
Photo 2 of 3 : UCIP\_SP\_2017\_39589\_62083.jpg

Pipe, flapgate, and headwall on WS toe.

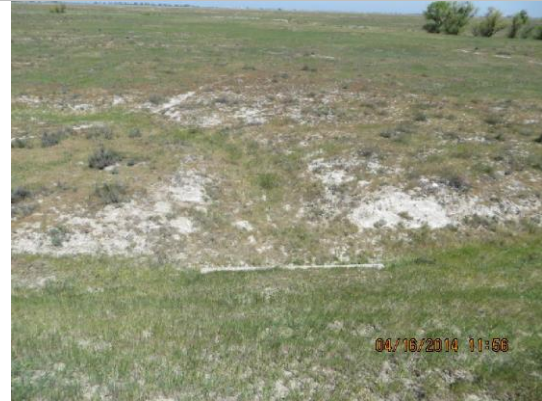
Photo 3 of 3 : UCIP\_SP\_2017\_39589\_62082.jpg

Pipe and headwall on LS toe.

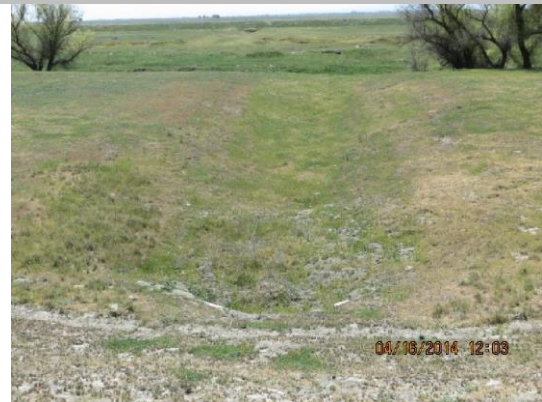
Photo 1 of 3 : UCIP\_SP\_2017\_39590\_62087.jpg

LM Start	4.89	Rating **	M	Issue No.	1323
LM End	4.89	Issue Type +	Ma	Location *	WS
Category	Supplemental			GPS Latitude/Longitude	
				Start	End
Item	DWR UCIP LMA Responsibility			37.240978 °	37.240978 °
				-120.751613 °	-120.751613 °
DWR ID					
Comment Code					
Inspector Comment					
FS_ID:39590 DS_ID:19772 EP_NO: N/A Repair Type: Non-Urgent Crossing Status: Found UCIP Comments: Heavy sediment buildup in pipe visible from landward side--recommend contacting owner to clear pipe. FIELD_STRUCT_DESC: 24-inch C.M. stormdrain pipe through the levee, 12.3-feet below the crown. Flap gate on the waterward end. Concrete headwall on the landward end. Concrete "U" headwall on the waterward end. (USACE-1967). This entry matches the Drainage or Irrigation Structure referenced in O&M manual (HLM 4.89). FS Date: 4/16/2014

Headwall, flapgate, and pipe on WS toe.

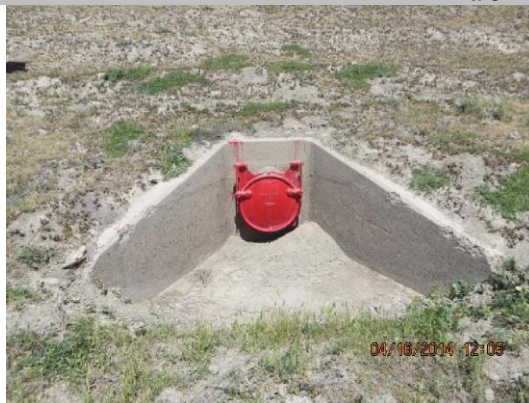
Photo 2 of 3 : UCIP\_SP\_2017\_39590\_62088.jpg

Headwall, flapgate, and pipe on WS toe.

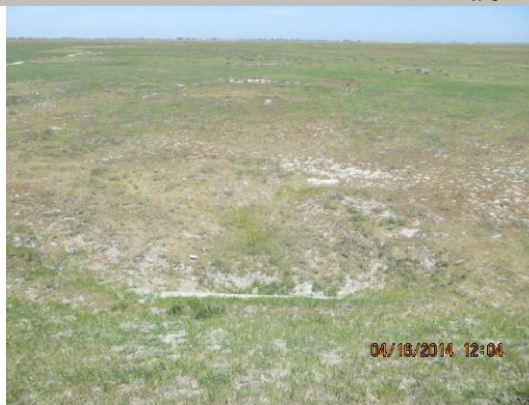
Photo 3 of 3 : UCIP\_SP\_2017\_39590\_62086.jpg

Headwall and pipe on LS toe.

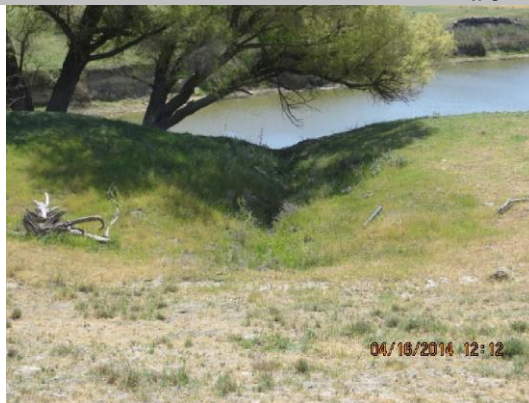
Photo 1 of 3 : UCIP\_SP\_2017\_39591\_62091.jpg

LM Start	5.15	Rating **	M	Issue No.	1324
LM End	5.15	Issue Type +	Ma	Location *	WS
Category	Supplemental			GPS Latitude/Longitude	
				Start	End
Item	DWR UCIP LMA Responsibility			37.240607 °	37.240607 °
				-120.746916 °	-120.746916 °
DWR ID					
Comment Code					
Inspector Comment					
FS_ID:39591 DS_ID:19773 EP_NO: N/A Repair Type: Non-Urgent Crossing Status: Found UCIP Comments: Heavy sediment buildup in pipe visible from landward side--recommend contacting owner to clear pipe. FIELD_STRUCT_DESC: 24-inch C.M. stormdrain pipe through the levee, 12.2-feet below the crown. Flap gate on the waterward end. Concrete headwall on the landward end. Concrete "U" headwall on the waterward end. (USACE-1967). This entry matches the Drainage or Irrigation Structure referenced in O&M manual (HLM 5.15). FS Date: 4/16/2014

Headwall, flapgate, and pipe on WS toe.

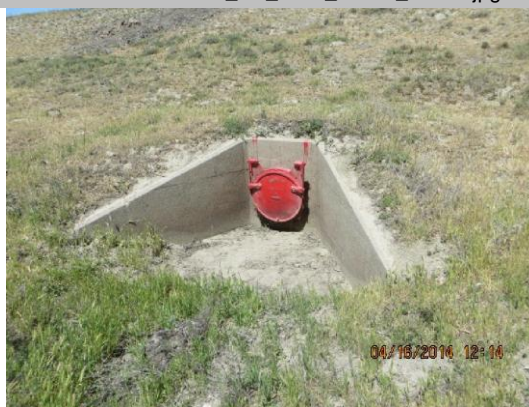
Photo 2 of 3 : UCIP\_SP\_2017\_39591\_62093.jpg

Headwall, flapgate, and pipe on WS toe.

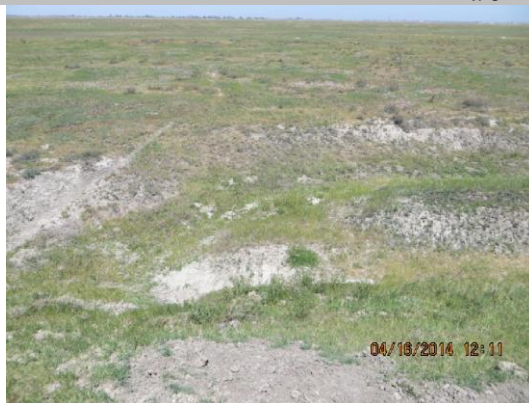
Photo 3 of 3 : UCIP\_SP\_2017\_39591\_62092.jpg

Headwall and pipe on LS toe.

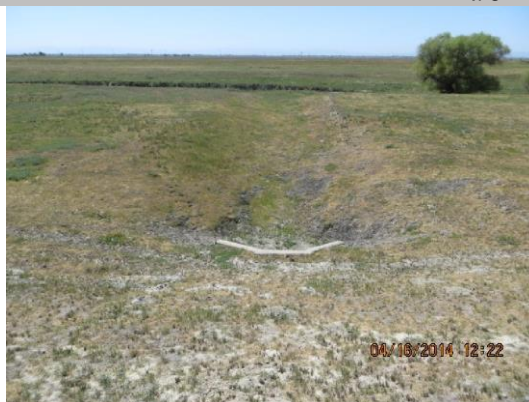
Photo 1 of 3 : UCIP\_SP\_2017\_34151\_62096.jpg

LM Start	5.58	Rating **	A/W	Issue No.	1325
LM End	5.58	Issue Type +	Ma	Location *	WS
Category	Supplemental			GPS Latitude/Longitude	
				Start	End
Item	DWR UCIP LMA Responsibility			37.238879 °	37.238879 °
				-120.739719 °	-120.739719 °
DWR ID					
Comment Code					
Inspector Comment					
FS_ID:34151					
DS_ID:19774					
EP_NO: N/A					
Repair Type: No Action Needed					
Crossing Status: Found					
UCIP Comments:					
FIELD_STRUCT_DESC: 24-inch C.M. stormdrain pipe through the levee, 9.5-feet below the crown. Flap gate on the waterward end. Concrete headwall on the landward end. Concrete "U" headwall on the waterward end. (USACE-1967). This entry matches the Drainage or Irrigation Structure referenced in O&M manual (HLM 5.58).					
FS Date: 4/16/2014

Headwall, flapgate, and pipe on WS toe.

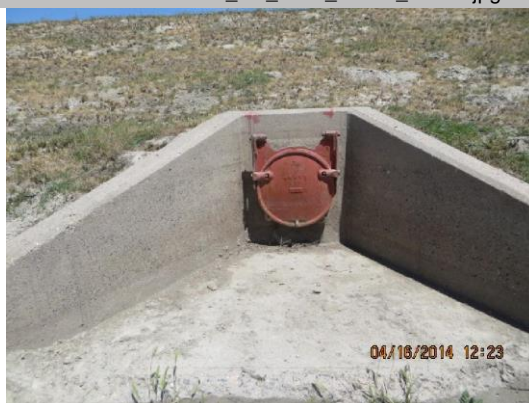
Photo 2 of 3 : UCIP\_SP\_2017\_34151\_62095.jpg

Headwall, flapgate, and pipe on WS toe.

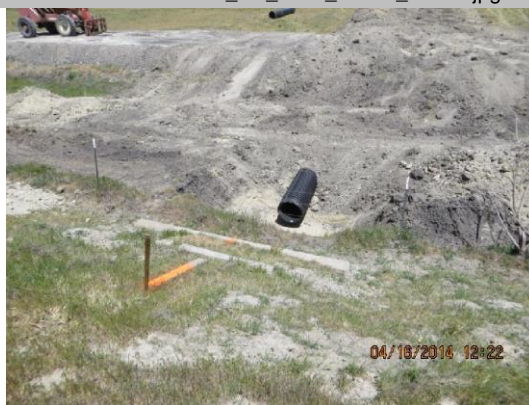
Photo 3 of 3 : UCIP\_SP\_2017\_34151\_62097.jpg

Headwall and pipe on LS toe with HDPE drain pipe being installed off LS toe.

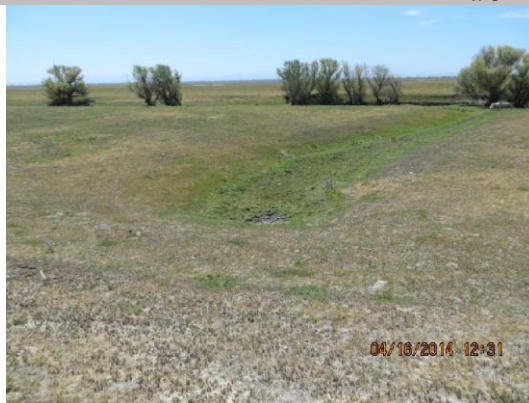
Photo 1 of 3 : UCIP\_SP\_2017\_34163\_62102.jpg

LM Start	6.35	Rating **	A/W	Issue No.	1326
LM End	6.35	Issue Type +	Ma	Location *	WS
Category	Supplemental			GPS Latitude/Longitude	
				Start	End
Item	DWR UCIP LMA Responsibility			37.232589 °	37.232589 °
				-120.728822 °	-120.728822 °
DWR ID					
Comment Code					
Inspector Comment					
FS_ID:34163					
DS_ID:19775					
EP_NO: N/A					
Repair Type: No Action Needed					
Crossing Status: Found					
UCIP Comments:					
FIELD_STRUCT_DESC: 24-inch C.M. stormdrain pipe through the					
levee, 13.0-feet below the crown. Flap gate on the waterward end.					
Concrete headwall on the landward end. Concrete "U" headwall on the					
waterward end. (USACE-1967). This entry matches the Drainage or					
Irrigation Structure referenced in O&M manual (HLM 6.35).					
FS Date: 4/16/2014

Headwall, flapgate, and pipe on WS toe.

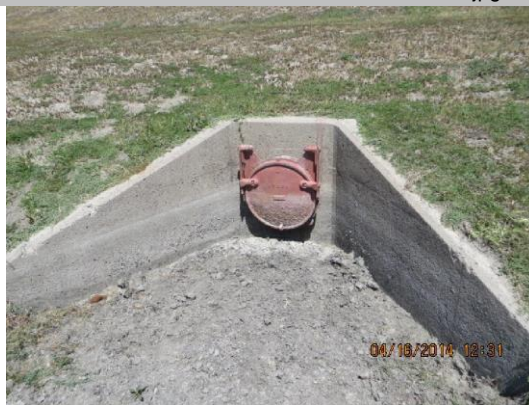
Photo 2 of 3 : UCIP\_SP\_2017\_34163\_62101.jpg

Headwall, flapgate, and pipe on WS toe.

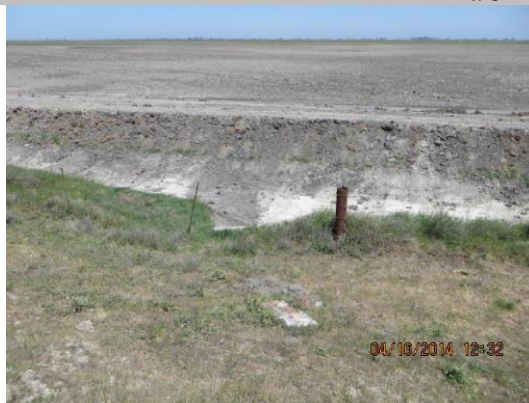
Photo 3 of 3 : UCIP\_SP\_2017\_34163\_62100.jpg

Headwall and pipe on LS toe.

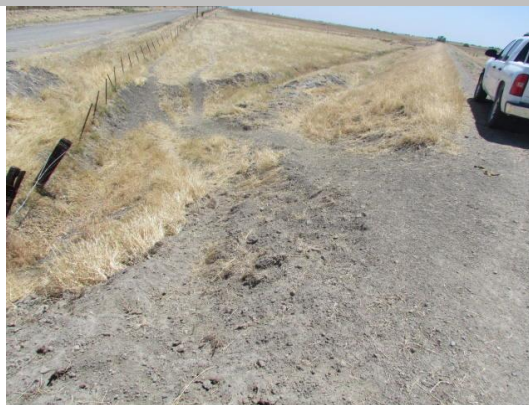
Photo 2 of 2 : SP\_2017\_NA0010\_123\_1309\_20170417\_00014.jpg

LM Start	6.59	Rating **	M	Issue No.	1309
LM End	6.59	Issue Type +	Ma	Location *	LS
Category	Earthen Levee			GPS Latitude/Longitude	
				Start	End
Item	Slope Stability			37.229682 °	37.229682 °
				-120.726305 °	-120.726305 °
DWR ID	DWR_NA0010_05_s_2015_1309				
Comment Code					
S2 : Repair the levee slope damaged by foot traffic and prevent access where possible.					
Inspector Comment					
Landward slope damage caused by animal foot traffic.

Looking east at damaged landward slope.

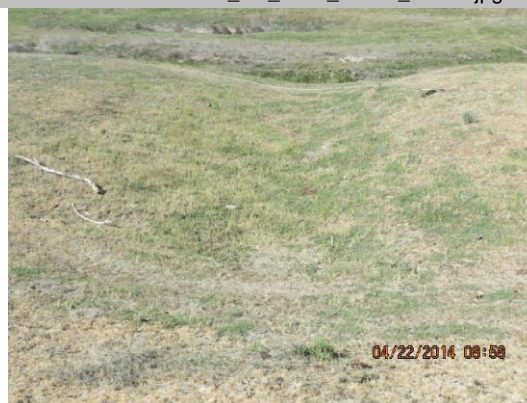
Photo 1 of 3 : UCIP\_SP\_2017\_39592\_62111.jpg

LM Start	7.36	Rating **	M	Issue No.	1327
LM End	7.36	Issue Type +	Ma	Location *	LS
Category	Supplemental			GPS Latitude/Longitude	
				Start	End
Item	DWR UCIP LMA Responsibility			37.224560 °	37.224560 °
				-120.714057 °	-120.714057 °
DWR ID					
Comment Code					
Inspector Comment					
FS_ID:39592 DS_ID:19761 EP_NO: N/A Repair Type: Non-Urgent Crossing Status: Found UCIP Comments: Sediment buildup in pipe visible from landward side--recommend contacting owner to clear pipe. FIELD_STRUCT_DESC: 24-inch C.M. stormdrain pipe through the levee, 12.0-feet below the crown. Flap gate on the waterward end. Concrete headwall on the landward end. Concrete "U" headwall on the waterward end. (USACE-1967). This entry matches the Drainage or Irrigation Structure referenced in O&M manual (HLM 7.36). FS Date: 4/22/2014

Headwall, flapgate, and pipe on WS toe.

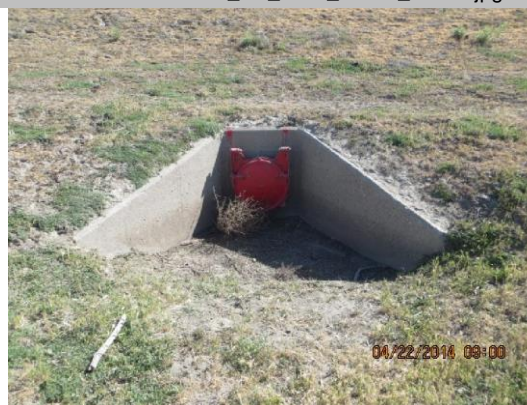
Photo 2 of 3 : UCIP\_SP\_2017\_39592\_62113.jpg

Headwall, flapgate, and pipe on WS toe.

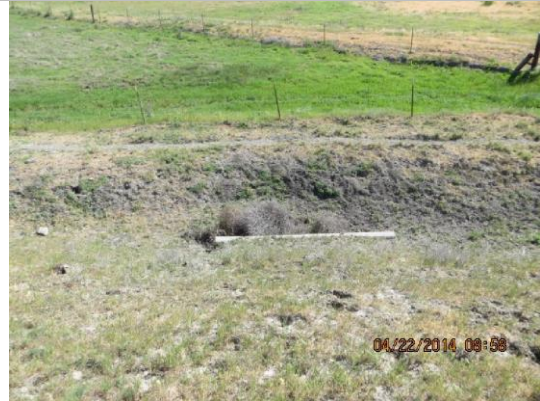
Photo 3 of 3 : UCIP\_SP\_2017\_39592\_62112.jpg

LM Start	7.36	Rating **	M	Issue No.	1327 (cont)
LM End	7.36	Issue Type +	Ma	Location *	LS
Category	Supplemental			GPS Latitude/Longitude	
				Start	End
Item	DWR UCIP LMA Responsibility			37.224560 °	37.224560 °
				-120.714057 °	-120.714057 °
DWR ID					
Comment Code					
Inspector Comment					
FS_ID:39592 DS_ID:19761 EP_NO: N/A Repair Type: Non-Urgent Crossing Status: Found UCIP Comments: Sediment buildup in pipe visible from landward side--recommend contacting owner to clear pipe. FIELD_STRUCT_DESC: 24-inch C.M. stormdrain pipe through the levee, 12.0-feet below the crown. Flap gate on the waterward end. Concrete headwall on the landward end. Concrete "U" headwall on the waterward end. (USACE-1967). This entry matches the Drainage or Irrigation Structure referenced in O&M manual (HLM 7.36). FS Date: 4/22/2014

Headwall and pipe on LS toe.

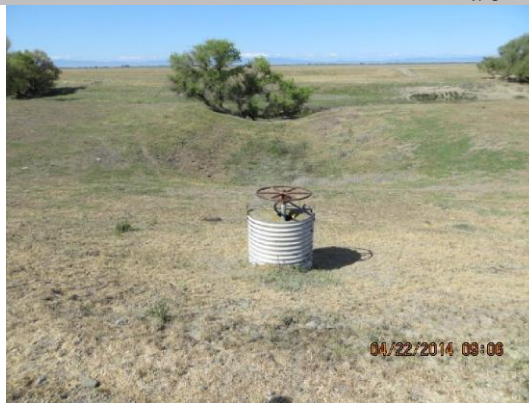
Photo 2 of 2 : UCIP\_SP\_2017\_34170\_62115.jpg

LM Start	7.58	Rating **	M	Issue No.	1328 (cont)	
LM End	7.58	Issue Type +	En	Location *	LS	
Category	Supplemental			GPS Latitude/Longitude		
				Start		End
Item	DWR UCIP Field Study			37.221465 °		37.221465 °
				-120.713780 °		-120.713780 °
DWR ID						
Comment Code						
Inspector Comment						
FS_ID:34170 DS_ID:19762 EP_NO: N/A Repair Type: Non-Urgent Crossing Status: Indicator Found UCIP Comments: Appears abandoned and if so should be done so properly. Slide gate rusted shut on WS slope. Unable to locate inlet or outlet. FIELD_STRUCT_DESC: 24-inch C.M. stormdrain pipe through the levee, 20.4 feet below the crown. Slide gate in 36-inch C.M. pipe riser unit in waterward slope. Concrete "U" headwalls on each end (not found 2014). (USACE-1967). This entry matches the Drainage or Irrigation Structure referenced in O&M manual (HLM 7.58). FS Date: 4/22/2014

Slide gate in CMP riser on WS slope. No outlet or pipe found on WS toe.

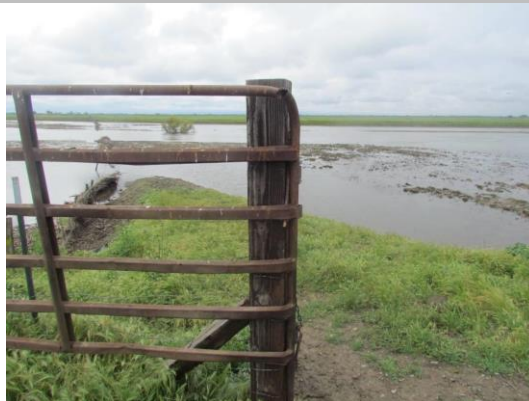
Photo 1 of 1 : SP\_2017\_NA0010\_123\_104\_20170424\_00284.jpg

LM Start	8.09	Rating **	M	Issue No.	104
LM End	8.09	Issue Type +	Ma	Location *	CR
Category	Earthen Levee			GPS Latitude/Longitude	
				Start	End
Item	Repair Gates			37.213580 °	37.213580 °
				-120.706550 °	-120.706550 °
DWR ID	DWR_NA0010_05_s_2017_104				
Comment Code					
Inspector Comment					
Replace or repair gate not opening correctly bend fence post.

Looking bend gate near hinge point.
