**Flood Control Project Maintenance  
Levee Inspections**  
**LMA District Cover Sheet**  
**Spring 2017 Levee Inspection Results**

**Lower San Joaquin Levee District**

Waterway			Bank	Unit Miles
Unit No. 01 San Joaquin River			Right	22.52
	Spring (March - May)	Summer (June - August)	(September - November) Fall	Winter (December - February)
Unit Maintenance Rating (Fall Only)				
Date of Inspection	4/17/2017 - 4/20/2017			
DWR Inspector	Richard Willoughby			
Accompanied By

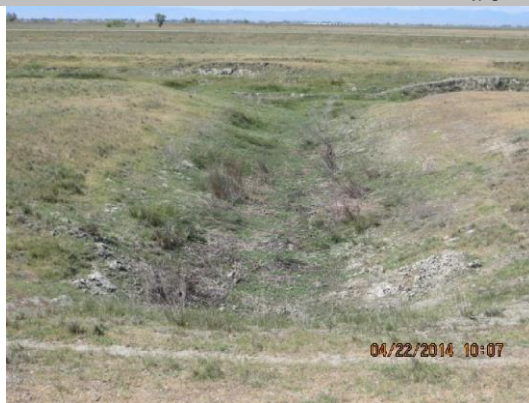
Photo 1 of 3 : UCIP\_SP\_2017\_34265\_62182.jpg

LM Start	8.46	Rating **	M	Issue No.	1329
LM End	8.46	Issue Type +	Ma	Location *	CR
Category	Supplemental			GPS Latitude/Longitude	
				Start	End
Item	DWR UCIP LMA Responsibility			37.209606 °	37.209606 °
				-120.702069 °	-120.702069 °
DWR ID					
Comment Code					
Inspector Comment					
FS_ID:34265					
DS_ID:19763					
EP_NO: N/A					
Repair Type: Non-Urgent					
Crossing Status: Found					
UCIP Comments: Pipe filled with silt on LS toe and should be cleared.					
FIELD_STRUCT_DESC: 24-inch CM stormdrain pipe through the levee,					
16.0-feet below the crown. Flap gate on the waterward end. Concrete					
headwall on the landward end. Concrete "U" headwalls on the					
waterward end. (USACE-1967). This entry matches the Drainage or					
Irrigation Structure referenced in O&M manual (HLM 8.44).					
FS Date: 4/22/2014

Headwall, flapgate, and pipe on WS toe

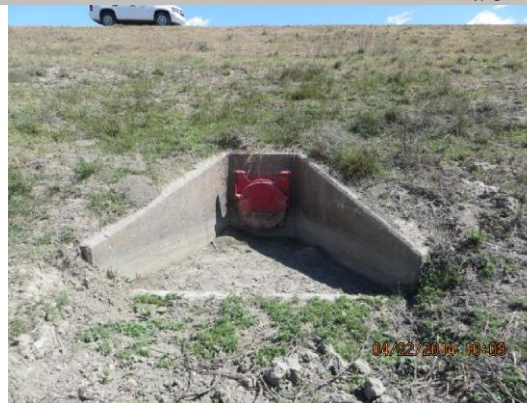
Photo 2 of 3 : UCIP\_SP\_2017\_34265\_62183.jpg

LM Start	8.46	Rating **	M	Issue No.	1329 (cont)	
LM End	8.46	Issue Type +	Ma	Location *	CR	
Category	Supplemental			GPS Latitude/Longitude		
				Start	End	
Item	DWR UCIP LMA Responsibility			37.209606 °	37.209606 °	
				-120.702069 °	-120.702069 °	
DWR ID						
Comment Code						
Inspector Comment						
FS_ID:34265						
DS_ID:19763						
EP_NO: N/A						
Repair Type: Non-Urgent						
Crossing Status: Found						
UCIP Comments: Pipe filled with silt on LS toe and should be cleared.						
FIELD_STRUCT_DESC: 24-inch CM stormdrain pipe through the levee,						
16.0-feet below the crown. Flap gate on the waterward end. Concrete						
headwall on the landward end. Concrete "U" headwalls on the						
waterward end. (USACE-1967). This entry matches the Drainage or						
Irrigation Structure referenced in O&M manual (HLM 8.44).						
FS Date: 4/22/2014

Headwall, flapgate, and pipe on WS toe

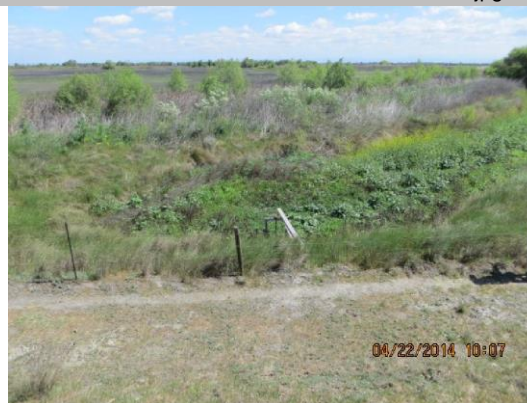
Photo 3 of 3 : UCIP\_SP\_2017\_34265\_62181.jpg

Headwall, slidegate, and pipe on LS toe.

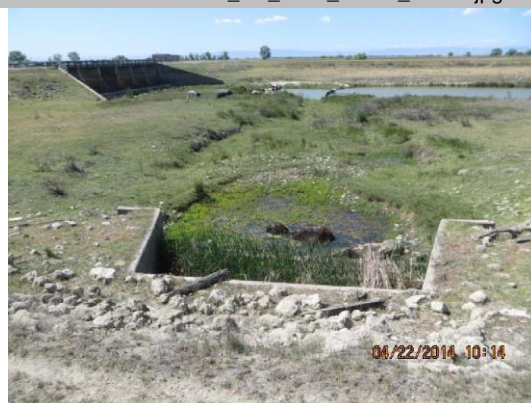
Photo 1 of 3 : UCIP\_SP\_2017\_34267\_62186.jpg

LM Start	8.85	Rating **	A/W	Issue No.	1330
LM End	8.85	Issue Type +	Ma	Location *	CR
Category	Supplemental			GPS Latitude/Longitude	
				Start	End
Item	DWR UCIP LMA Responsibility			37.205800 °	37.205800 °
				-120.696867 °	-120.696867 °
DWR ID					
Comment Code					
Inspector Comment					
FS_ID:34267 DS_ID:19764 EP_NO: N/A Repair Type: No Action Needed Crossing Status: Found UCIP Comments: FIELD_STRUCT_DESC: 1 of 2: 48x102-inch R.C.B.C. stormdrains through the levee, 13.8-feet below the crown. Concrete "U" headwall on the waterward end. Concrete headwall on the landward end with slide gates mounted on the headwall. Waterward slope and outlet drain cobble revetted. (USACE-1967). This entry matches the Drainage or Irrigation Structure referenced in O&M manual (HLM 8.83). [Deadman Creek Drainage Ditch Structure] FS Date: 4/22/2014

Concrete headwall at outlet on WS toe.

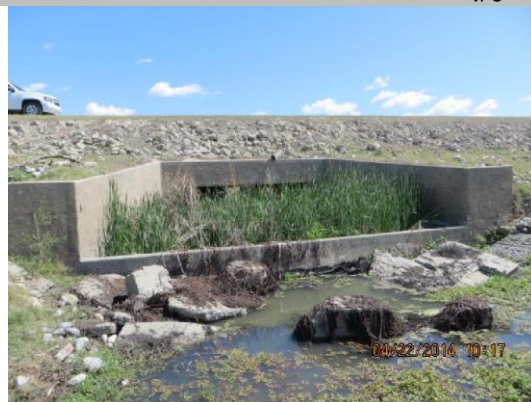
Photo 2 of 3 : UCIP\_SP\_2017\_34267\_62187.jpg

Concrete headwall at outlet on WS toe.

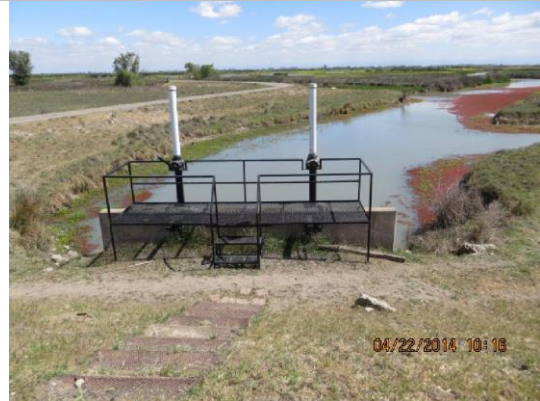
Photo 3 of 3 : UCIP\_SP\_2017\_34267\_62185.jpg

LM Start	8.85	Rating **	A/W	Issue No.	1330 (cont)
LM End	8.85	Issue Type +	Ma	Location *	CR
Category	Supplemental			GPS Latitude/Longitude	
				Start	End
Item	DWR UCIP LMA Responsibility			37.205800 °	37.205800 °
				-120.696867 °	-120.696867 °
DWR ID					
Comment Code					
Inspector Comment					
FS_ID:34267					
DS_ID:19764					
EP_NO: N/A					
Repair Type: No Action Needed					
Crossing Status: Found					
UCIP Comments:					
FIELD_STRUCT_DESC: 1 of 2: 48x102-inch R.C.B.C. stormdrains through the levee, 13.8-feet below the crown. Concrete "U" headwall on the waterward end. Concrete headwall on the landward end with slide gates mounted on the headwall. Waterward slope and outlet drain cobble revetted. (USACE-1967). This entry matches the Drainage or Irrigation Structure referenced in O&M manual (HLM 8.83). [Deadman Creek Drainage Ditch Structure]					
FS Date: 4/22/2014

Slide gate mounted on concrete headwall at LS toe.

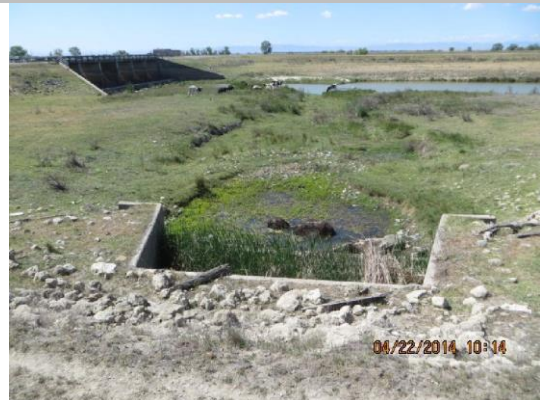
Photo 1 of 3 : UCIP\_SP\_2017\_34268\_62190.jpg

LM Start	8.85	Rating **	A/W	Issue No.	1331
LM End	8.85	Issue Type +	Ma	Location *	CR
Category	Supplemental			GPS Latitude/Longitude	
				Start	End
Item	DWR UCIP LMA Responsibility			37.205784 °	37.205784 °
				-120.696843 °	-120.696843 °
DWR ID					
Comment Code					
Inspector Comment					
FS_ID:34268 DS_ID:19735 EP_NO: N/A Repair Type: No Action Needed Crossing Status: Found UCIP Comments: FIELD_STRUCT_DESC: 2 of 2: 48x102-inch R.C.B.C. stormdrain through the levee, 13.8-feet below the crown. Concrete "U" headwall on the waterward end. Concrete headwall on the landward end with slide gates mounted on the headwall. Waterward slope and outlet drain cobble revetted. (USACE-1967). This entry matches the Drainage or Irrigation Structure referenced in O&M manual (HLM 8.83). [Deadman Creek Drainage Ditch Structure] FS Date: 4/22/2014

Concrete headwall on WS toe.

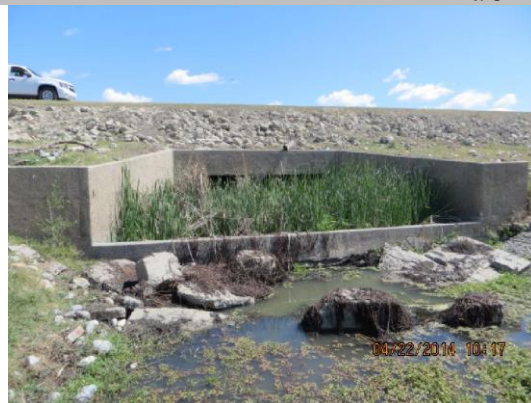
Photo 2 of 3 : UCIP\_SP\_2017\_34268\_62191.jpg

Concrete headwall on WS toe.

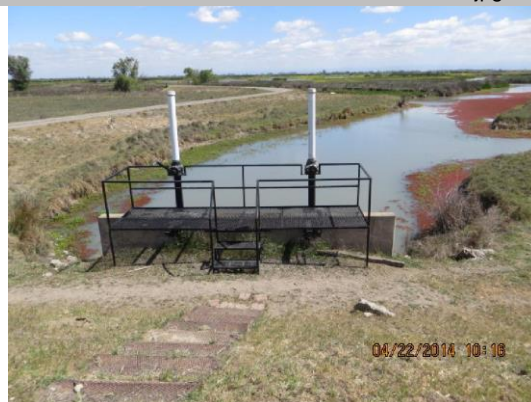
Photo 3 of 3 : UCIP\_SP\_2017\_34268\_62189.jpg

Slide gate mounted on concrete headwall at LS toe.

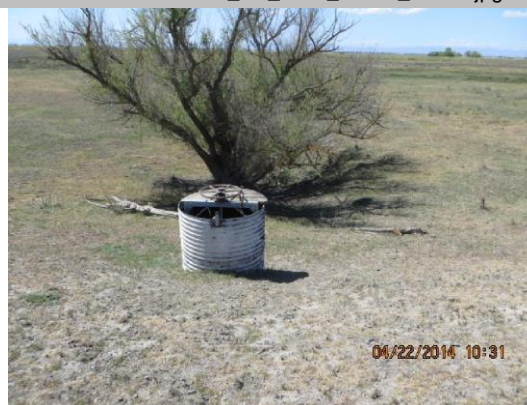
Photo 1 of 3 : UCIP\_SP\_2017\_34272\_62196.jpg

LM Start	9.28	Rating **	A/W	Issue No.	1332
LM End	9.28	Issue Type +	Ma	Location *	WS
Category	Supplemental			GPS Latitude/Longitude	
				Start	End
Item	DWR UCIP LMA Responsibility			37.202742 °	37.202742 °
				-120.690064 °	-120.690064 °
DWR ID					
Comment Code					
Inspector Comment					
FS_ID:34272					
DS_ID:19766					
EP_NO: N/A					
Repair Type: No Action Needed					
Crossing Status: Found					
UCIP Comments:					
FIELD_STRUCT_DESC: 36-inch CM stormdrain pipe through the levee, 14.8-feet below the crown. Slide gate in a 48-inch CM pipe riser in the waterward slope. Concrete headwall on both ends. (USACE-1967). This entry matches the Drainage or Irrigation Structure referenced in O&M manual (HLM 9.26).					
FS Date: 4/22/2014

Slide gate in 48-inch CMP riser on WS slope.

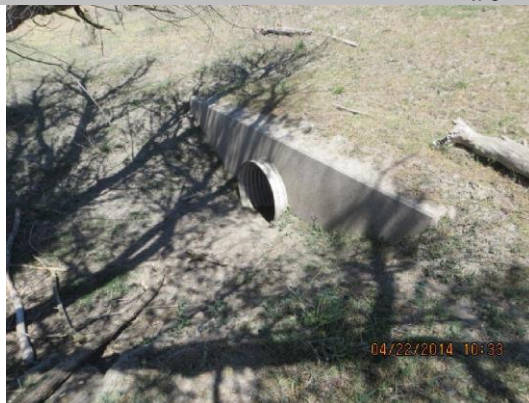
Photo 2 of 3 : UCIP\_SP\_2017\_34272\_62198.jpg

LM Start	9.28	Rating **	A/W	Issue No.	1332 (cont)	
LM End	9.28	Issue Type +	Ma	Location *	WS	
Category	Supplemental			GPS Latitude/Longitude		
				Start	End	
Item	DWR UCIP LMA Responsibility			37.202742 °	37.202742 °	
				-120.690064 °	-120.690064 °	
DWR ID						
Comment Code						
Inspector Comment						
FS_ID:34272						
DS_ID:19766						
EP_NO: N/A						
Repair Type: No Action Needed						
Crossing Status: Found						
UCIP Comments:						
FIELD_STRUCT_DESC: 36-inch CM stormdrain pipe through the levee, 14.8-feet below the crown. Slide gate in a 48-inch CM pipe riser in the waterward slope. Concrete headwall on both ends. (USACE-1967). This entry matches the Drainage or Irrigation Structure referenced in O&M manual (HLM 9.26).						
FS Date: 4/22/2014

Headwall and pipe at WS toe.

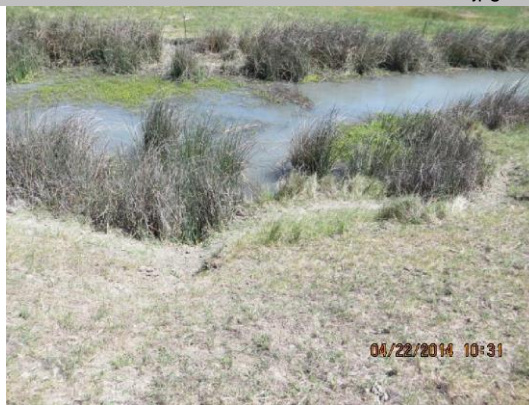
Photo 3 of 3 : UCIP\_SP\_2017\_34272\_62197.jpg

Headwall and pipe at LS toe.

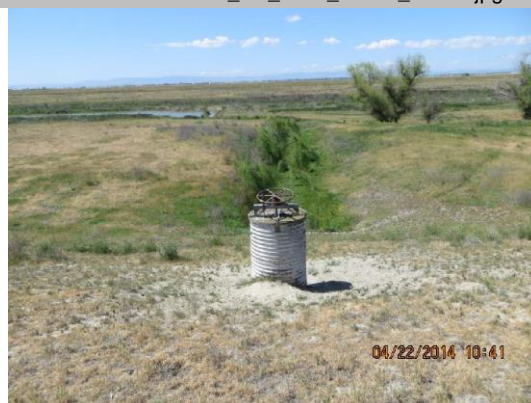
Photo 1 of 3 : UCIP\_SP\_2017\_34273\_62201.jpg

LM Start	10.06	Rating **	M	Issue No.	1333
LM End	10.06	Issue Type +	Ma	Location *	WS
Category	Supplemental			GPS Latitude/Longitude	
				Start	End
Item	DWR UCIP LMA Responsibility			37.194736 °	37.194736 °
				-120.680116 °	-120.680116 °
DWR ID					
Comment Code					
Inspector Comment					
FS_ID:34273 DS_ID:19767 EP_NO: N/A Repair Type: Non-Urgent Crossing Status: Found UCIP Comments: Slidegate actuator appears bent and may not work properly (WS slope). FIELD_STRUCT_DESC: 24-inch CM stormdrain pipe through the levee, 15.0-feet below the crown. Slide gate in 36-inch CM pipe riser on the waterward slope. Concrete headwall on both ends. (USACE-1967). This entry matches the Drainage or Irrigation Structure referenced in O&M manual (HLM 10.05). FS Date: 4/22/2014

Slidegate in CMP riser on WS slope.

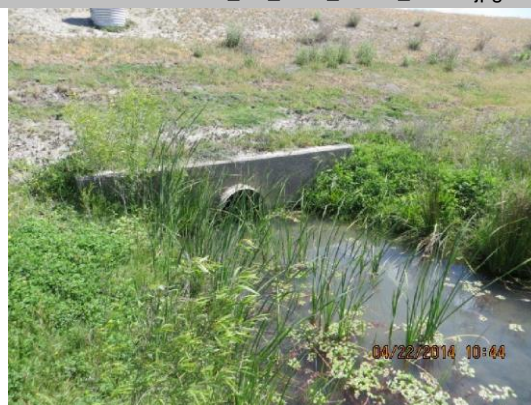
Photo 2 of 3 : UCIP\_SP\_2017\_34273\_62202.jpg

Concrete headwall and pipe on WS toe.

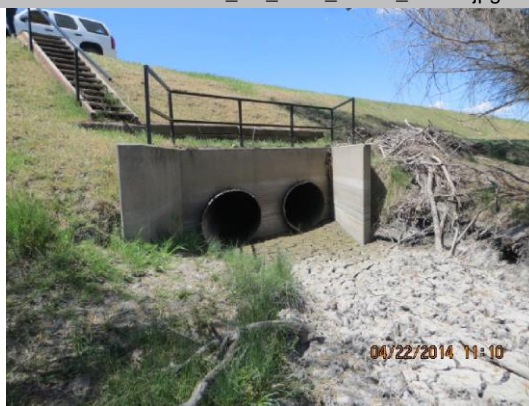
Photo 2 of 3 : UCIP\_SP\_2017\_34281\_62217.jpg

LM Start	11.49	Rating **	A/W	Issue No.	1334 (cont)
LM End	11.49	Issue Type +	Ma	Location *	WS
Category	Supplemental			GPS Latitude/Longitude	
				Start	End
Item	DWR UCIP LMA Responsibility			37.186471 °	37.186471 °
				-120.657915 °	-120.657915 °
DWR ID					
Comment Code					
Inspector Comment					
FS_ID:34281 DS_ID:19768 EP_NO: N/A Repair Type: No Action Needed Crossing Status: Found UCIP Comments: FIELD_STRUCT_DESC: 1 of 2: 48-inch CM stormdrain pipe through the levee, 16.0-feet below the crown. Slide gates in 60-inch CM pipe risers in the waterward slope. Concrete "U" headwalls on both ends. (USACE-1967). This entry matches the Drainage or Irrigation Structure referenced in O&M manual (HLM 11.48). Stairs on LS slope. [Deadman Drain Structure] FS Date: 4/22/2014

Stairs, concrete headwall, and pipe visible on LS slope.

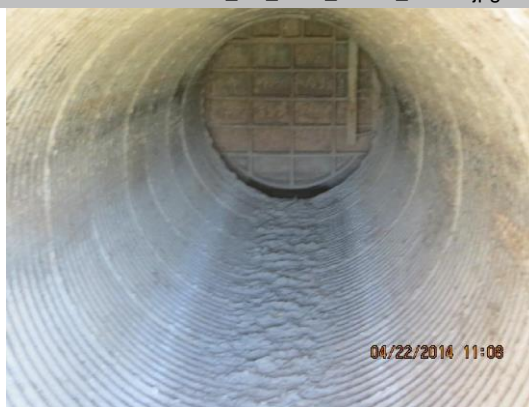
Photo 3 of 3 : UCIP\_SP\_2017\_34281\_62218.jpg

Inside pipe at LS toe.

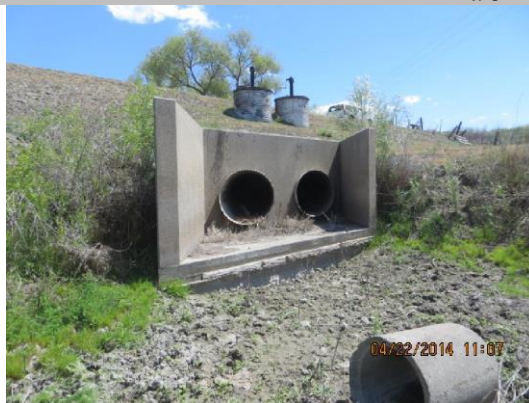
Photo 1 of 3 : UCIP\_SP\_2017\_34280\_62216.jpg

LM Start	11.50	Rating **	A/W	Issue No.	1335
LM End	11.50	Issue Type +	Ma	Location *	WS
Category	Supplemental			GPS Latitude/Longitude	
				Start	End
Item	DWR UCIP LMA Responsibility			37.186458 °	37.186458 °
				-120.657903 °	-120.657903 °
DWR ID					
Comment Code					
Inspector Comment					
FS_ID:34280					
DS_ID:19734					
EP_NO: N/A					
Repair Type: No Action Needed					
Crossing Status: Found					
UCIP Comments:					
FIELD_STRUCT_DESC: 2 of 2: 48-inch CM stormdrain pipe through the levee, 16.0 feet below the crown. Slide gate in 60-inch CM pipe riser on the waterward slope. Concrete "U" headwalls on both ends. (USACE-1967). This entry matches the Drainage or Irrigation Structure referenced in O&M manual (HLM 11.48). [Deadman Drain Structure]					
FS Date: 4/22/2014

Concrete headwall, pipe, and slidegate in CMP riser on WS of levee.

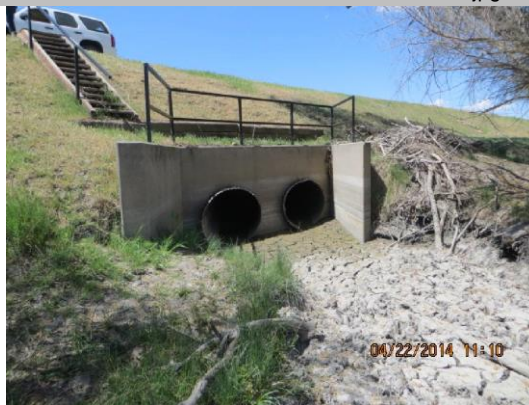
Photo 2 of 3 : UCIP\_SP\_2017\_34280\_62214.jpg

Stairs, concrete headwall and pipe on LS toe.

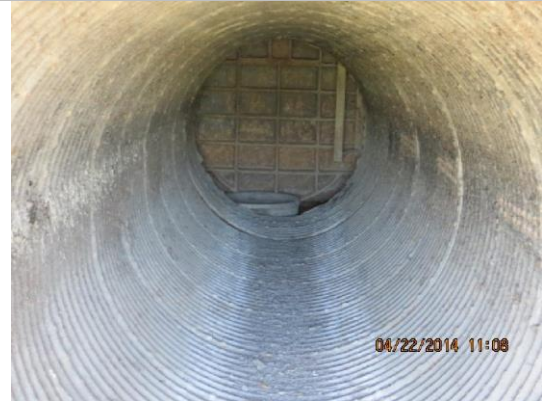
Photo 3 of 3 : UCIP\_SP\_2017\_34280\_62215.jpg

LM Start	11.50	Rating **	A/W	Issue No.	1335 (cont)	
LM End	11.50	Issue Type +	Ma	Location *	WS	
Category	Supplemental			GPS Latitude/Longitude		
				Start		End
Item	DWR UCIP LMA Responsibility			37.186458 °		37.186458 °
				-120.657903 °		-120.657903 °
DWR ID						
Comment Code						
Inspector Comment						
FS_ID:34280						
DS_ID:19734						
EP_NO: N/A						
Repair Type: No Action Needed						
Crossing Status: Found						
UCIP Comments:						
FIELD_STRUCT_DESC: 2 of 2: 48-inch CM stormdrain pipe through the levee, 16.0 feet below the crown. Slide gate in 60-inch CM pipe riser on the waterward slope. Concrete "U" headwalls on both ends. (USACE-1967). This entry matches the Drainage or Irrigation Structure referenced in O&M manual (HLM 11.48). [Deadman Drain Structure]						
FS Date: 4/22/2014

Inside pipe on WS toe.

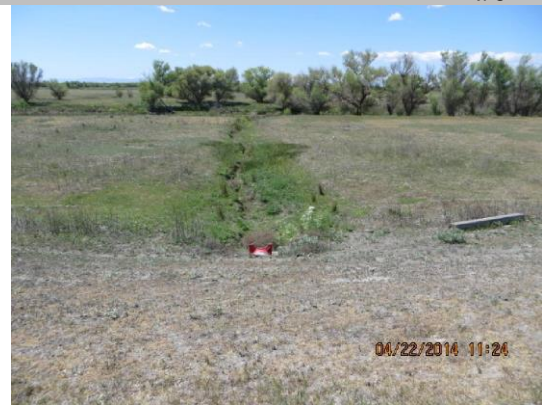
Photo 1 of 3 : UCIP\_SP\_2017\_34283\_62221.jpg

LM Start	11.65	Rating **	A/W	Issue No.	1336
LM End	11.65	Issue Type +	Ma	Location *	WS
Category	Supplemental			GPS Latitude/Longitude	
				Start	End
Item	DWR UCIP LMA Responsibility			37.184830 °	37.184830 °
				-120.656016 °	-120.656016 °
DWR ID					
Comment Code					
Inspector Comment					
FS_ID:34283 DS_ID:19704 EP_NO: N/A Repair Type: No Action Needed Crossing Status: Found UCIP Comments: FIELD_STRUCT_DESC: 24-inch CM stormdrain pipe through the levee, 11.8-feet below the crown. Flap gate on the waterward end. Concrete headwall on the landward end. Concrete saddle and apron on the waterward end. (USACE-1967). This entry matches the Drainage or Irrigation Structure referenced in O&M manual (HLM 11.63). FS Date: 4/22/2014

Headwall, flapgate, and pipe at WS toe.

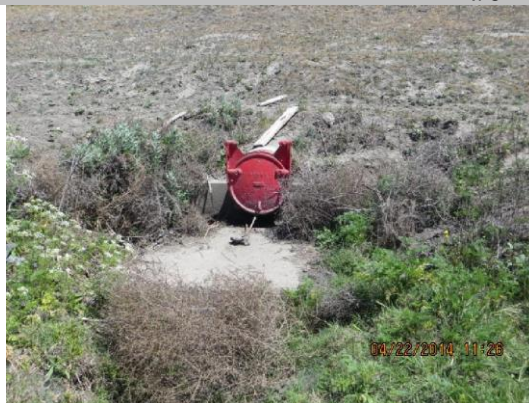
Photo 2 of 3 : UCIP\_SP\_2017\_34283\_62223.jpg

Headwall, flapgate, and pipe at WS toe.

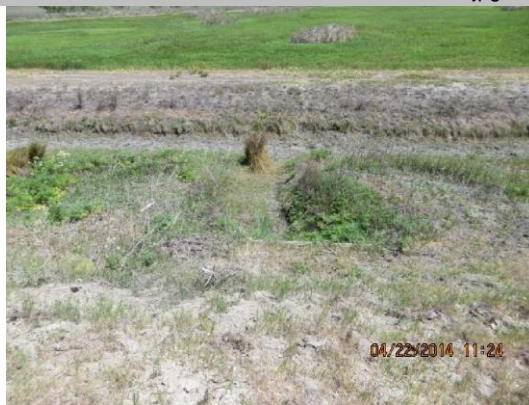
Photo 3 of 3 : UCIP\_SP\_2017\_34283\_62222.jpg

Concrete headwall and pipe at LS toe.

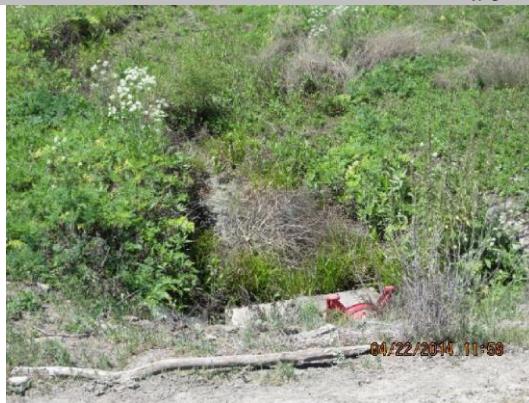
Photo 1 of 3 : UCIP\_SP\_2017\_34284\_62225.jpg

LM Start	12.01	Rating **	A/W	Issue No.	1337
LM End	12.01	Issue Type +	Ma	Location *	WS
Category	Supplemental			GPS Latitude/Longitude	
				Start	End
Item	DWR UCIP LMA Responsibility			37.180291 °	37.180291 °
				-120.653931 °	-120.653931 °
DWR ID					
Comment Code					
Inspector Comment					
FS_ID:34284 DS_ID:19705 EP_NO: N/A Repair Type: No Action Needed Crossing Status: Found UCIP Comments: FIELD_STRUCT_DESC: 24-inch CM stormdrain pipe through the levee, 12.5 feet below the crown. Flap gate on the waterward end. Concrete headwall on the landward end. Concrete headwall on the landward end. Concrete saddle and apron on the waterward end. Flashboard attachment on the landward end. (USACE-1967). This entry matches the Drainage or Irrigation Structure referenced in O&M manual (HLM 11.99). FS Date: 4/22/2014

Headwall, flapgate, and pipe on WS toe.

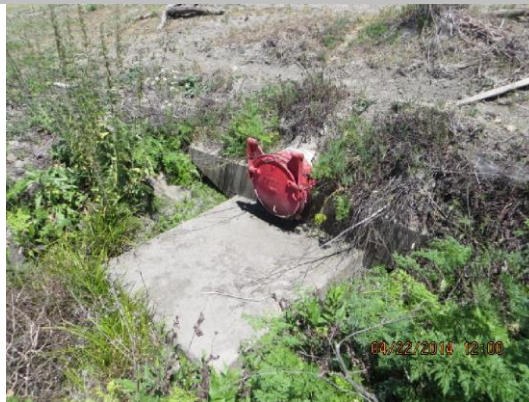
Photo 2 of 3 : UCIP\_SP\_2017\_34284\_62227.jpg

Headwall, flapgate, and pipe on WS toe.

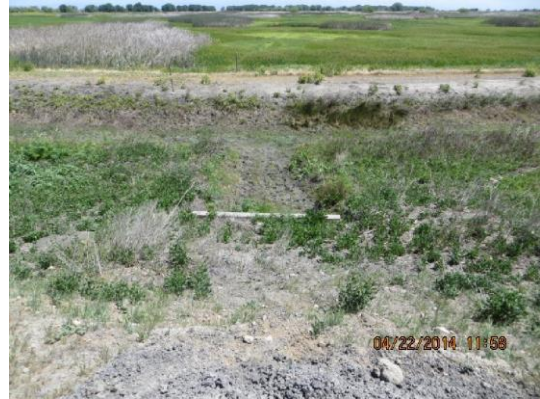
Photo 3 of 3 : UCIP\_SP\_2017\_34284\_62226.jpg

Headwall and pipe on LS toe.

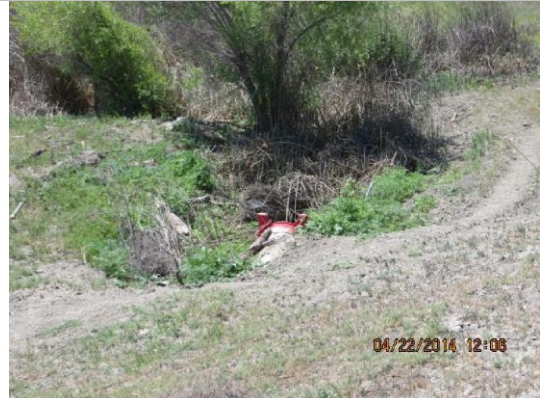
Photo 1 of 3 : UCIP\_SP\_2017\_34285\_62230.jpg

LM Start	12.40	Rating **	A/W	Issue No.	1338
LM End	12.40	Issue Type +	Ma	Location *	WS
Category	Supplemental			GPS Latitude/Longitude	
				Start	End
Item	DWR UCIP LMA Responsibility			37.175958 °	37.175958 °
				-120.649798 °	-120.649798 °
DWR ID					
Comment Code					
Inspector Comment					
FS_ID:34285 DS_ID:19706 EP_NO: N/A Repair Type: No Action Needed Crossing Status: Found UCIP Comments: FIELD_STRUCT_DESC: 24-inch CM stormdrain pipe through the levee, 10.2-feet below the crown. Flap gate on the waterward end. Concrete headwall on the landward end. Concrete saddle and apron on the waterward end. Flashboard attachment on the landward end. (USACE-1967). This entry matches the Drainage or Irrigation Structure referenced in O&M manual (HLM 12.38). Pipe crosses levee at 45 degrees to crown alignment. FS Date: 4/22/2014

Headwall, flapgate, and pipe on WS toe.

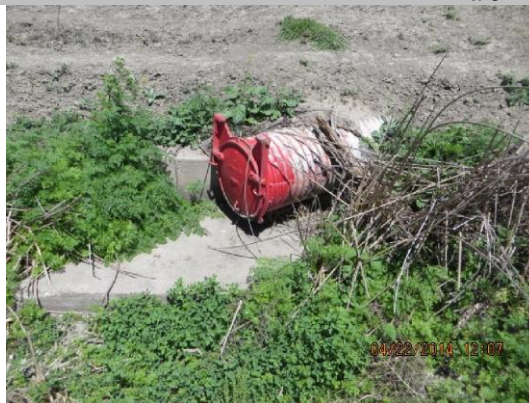
Photo 2 of 3 : UCIP\_SP\_2017\_34285\_62229.jpg

Headwall, flapgate, and pipe on WS toe.

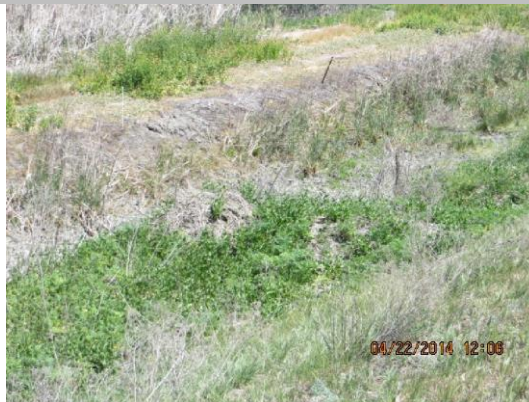
Photo 3 of 3 : UCIP\_SP\_2017\_34285\_62231.jpg

Headwall and pipe on LS toe.

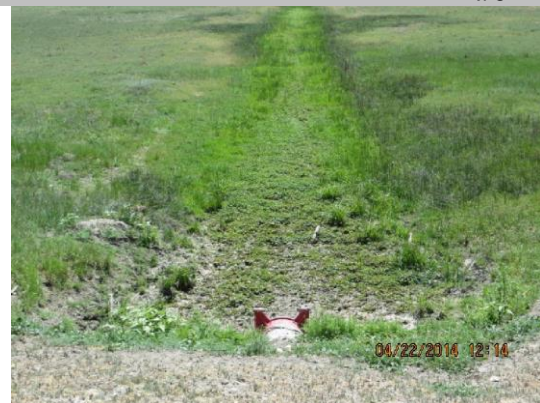
Photo 1 of 3 : UCIP\_SP\_2017\_39593\_62240.jpg

LM Start	12.89	Rating **	M	Issue No.	1339
LM End	12.89	Issue Type +	Ma	Location *	LS
Category	Supplemental			GPS Latitude/Longitude	
				Start	End
Item	DWR UCIP LMA Responsibility			37.175816 °	37.175816 °
				-120.640865 °	-120.640865 °
DWR ID					
Comment Code					
Inspector Comment					
FS_ID:39593 DS_ID:19707 EP_NO: N/A Repair Type: Non-Urgent Crossing Status: Found UCIP Comments: Sediment buildup in pipe visible from landward side-- recommend contacting owner to clear pipe. FIELD_STRUCT_DESC: 24-inch CM stormdrain pipe through the levee, 10.2-feet below the crown. Flap gate on the waterward end. Concrete headwalls on the landward end with flashboards. Concrete saddle and apron on the waterward end with a flapgate. Metal screen at LS toe inlet (USACE-1967). This entry matches the Drainage or Irrigation Structure referenced in O&M manual (HLM 12.87). FS Date: 4/22/2014

Headwall, flapgate, and pipe on WS toe.

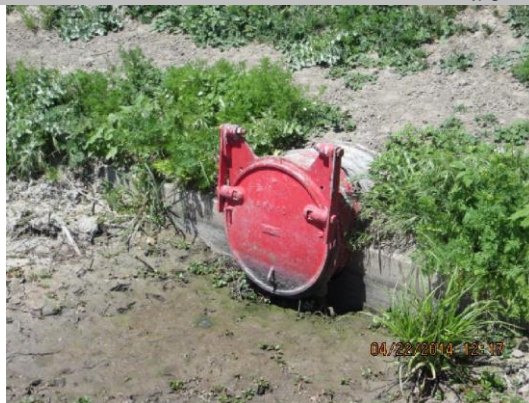
Photo 2 of 3 : UCIP\_SP\_2017\_39593\_62241.jpg

Headwall, flapgate, and pipe on WS toe.

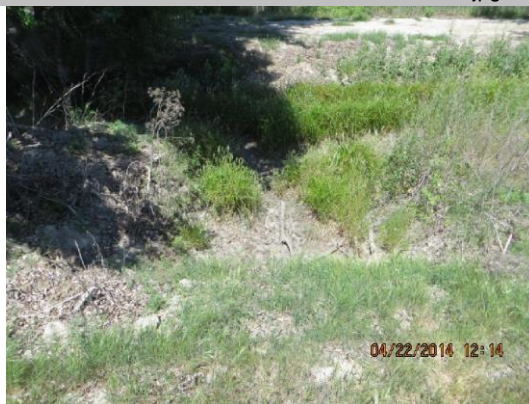
Photo 3 of 3 : UCIP\_SP\_2017\_39593\_62239.jpg

Headwall and pipe on LS toe.

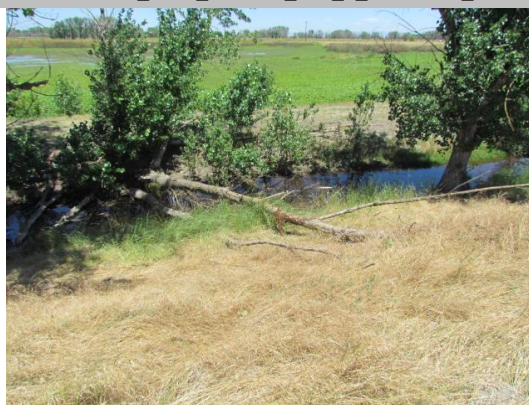
Photo 1 of 1 : SP\_2017\_NA0010\_123\_2\_20170417\_00001.jpg

LM Start	13.01	Rating **	M	Issue No.	2
LM End	13.01	Issue Type +	Ma	Location *	LS
Category	Earthen Levee			GPS Latitude/Longitude	
				Start	End
Item	Encroachments			37.175576 °	37.175576 °
				-120.638755 °	-120.638755 °
DWR ID	DWR_NA0010_05_s _ 2016_2				
Comment Code					
TR : Tree or limb					
Inspector Comment					
Downed tree on landward toe.

Looking west at down tree at landward toe.

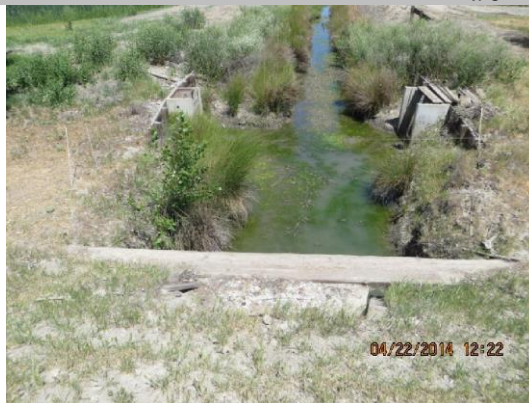
Photo 1 of 3 : UCIP\_SP\_2017\_34288\_62244.jpg

LM Start	13.42	Rating **	M	Issue No.	1340
LM End	13.42	Issue Type +	Ma	Location *	LS
Category	Supplemental			GPS Latitude/Longitude	
				Start	End
Item	DWR UCIP LMA Responsibility			37.171523 °	37.171523 °
				-120.633442 °	-120.633442 °
DWR ID					
Comment Code					
Inspector Comment					
FS_ID:34288					
DS_ID:19708					
EP_NO: N/A					
Repair Type: Non-Urgent					
Crossing Status: Found					
UCIP Comments: Some erosion around headwall on the WS toe and there are animal burrows on both slopes.					
FIELD_STRUCT_DESC: 48-inch C.M. stormdrain pipe through the levee, 10.0-feet below the crown. Flap gate on the waterward end.					
Flashboard attachment in concrete "U" headwall on the landward end.					
Concrete "U" headwall on the waterward end. (USACE-1967). This entry matches the Drainage or Irrigation Structure referenced in O&M manual (HLM 13.40).					
FS Date: 4/22/2014

Headwall and pipe on LS toe.

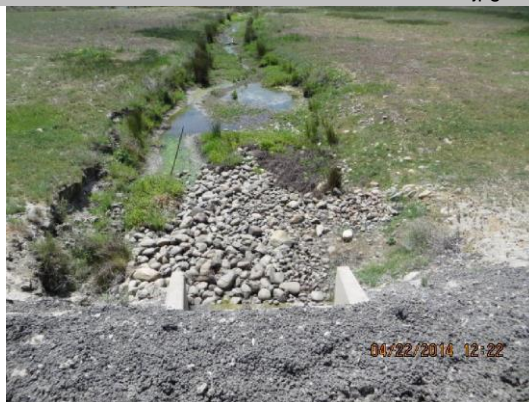
Photo 2 of 3 : UCIP\_SP\_2017\_34288\_62243.jpg

Headwall, flapgate, and pipe on WS toe.

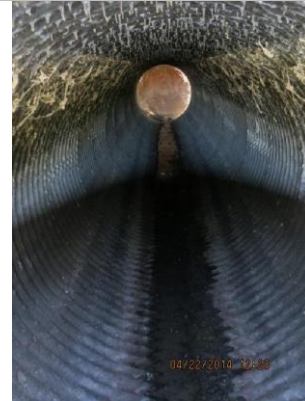
Photo 3 of 3 : UCIP\_SP\_2017\_34288\_62242.jpg

Headwall, flapgate, and pipe on WS toe.

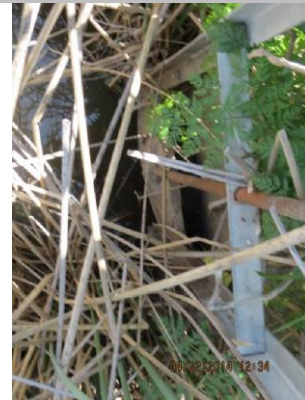
Photo 1 of 2 : UCIP\_SP\_2017\_34824\_62624.jpg

LM Start	13.72	Rating **	M	Issue No.	1341
LM End	13.72	Issue Type +	Ma	Location *	LS
Category	Supplemental			GPS Latitude/Longitude	
				Start	End
Item	DWR UCIP LMA Responsibility			37.168202 °	37.168202 °
				-120.629886 °	-120.629886 °
DWR ID					
Comment Code					
Inspector Comment					
FS_ID:34824 DS_ID:19709 EP_NO: N/A Repair Type: Non-Urgent Crossing Status: Found UCIP Comments: Pipe not visible and may need to have silt removed from outlet on WS toe. FIELD_STRUCT_DESC: 24-inch C.M. stormdrain pipe through the levee, 16-feet below the crown. Flap gate on the waterward end. Slidegate on concrete headwall at LS toe. Concrete saddle and apron on the waterward end. (USACE-1967). This entry matches the Drainage or Irrigation Structure referenced in O&M manual (HLM 13.72). FS Date: 4/22/2014

Slide gate at concrete headwall on LS toe.

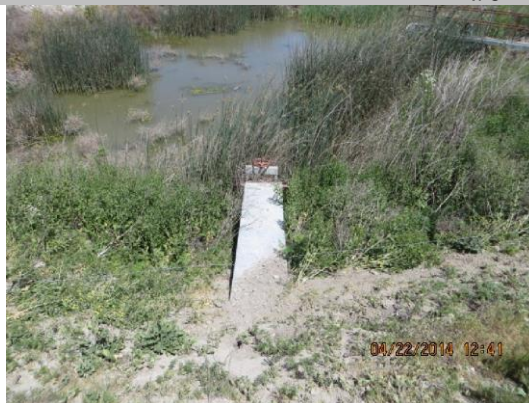
Photo 2 of 2 : UCIP\_SP\_2017\_34824\_62623.jpg

Walkway to gatevalve on LS shoulder.

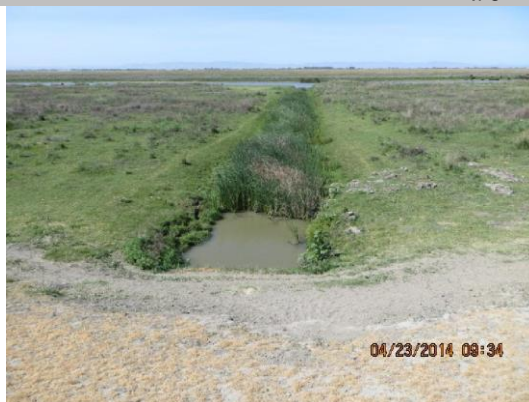
Photo 1 of 3 : UCIP\_SP\_2017\_34657\_62450.jpg

LM Start	13.85	Rating **	A/W	Issue No.	1342
LM End	13.85	Issue Type +	Ma	Location *	LS
Category	Supplemental			GPS Latitude/Longitude	
				Start	End
Item	DWR UCIP LMA Responsibility			37.166760 °	37.166760 °
				-120.628304 °	-120.628304 °
DWR ID					
Comment Code					
Inspector Comment					
FS_ID:34657 DS_ID:19710 EP_NO: N/A Repair Type: No Action Needed Crossing Status: Found UCIP Comments: FIELD_STRUCT_DESC: 24-inch C.M. stormdrain pipe through the levee, 12.4 feet below the crown. Flap gate on the waterward end. Concrete headwall on both ends. (USACE-1967). This entry matches the Drainage or Irrigation Structure referenced in O&M manual (HLM 13.83). FS Date: 4/23/2014 4:17:00 PM

Headwall, flapgate, and pipe on WS toe.

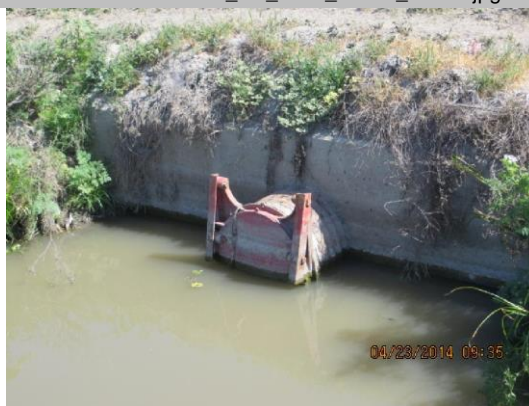
Photo 2 of 3 : UCIP\_SP\_2017\_34657\_62448.jpg

Headwall, flapgate, and pipe on WS toe.

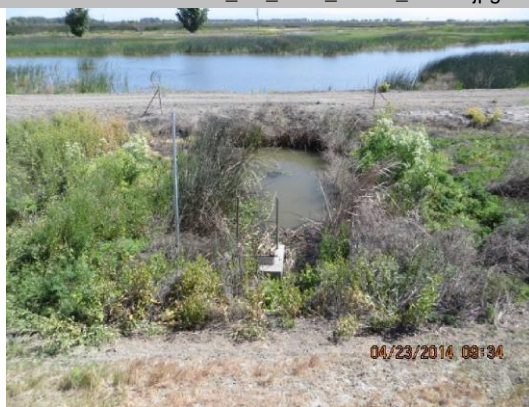
Photo 3 of 3 : UCIP\_SP\_2017\_34657\_62449.jpg

Concrete wier intake structure and pipe at LS toe.

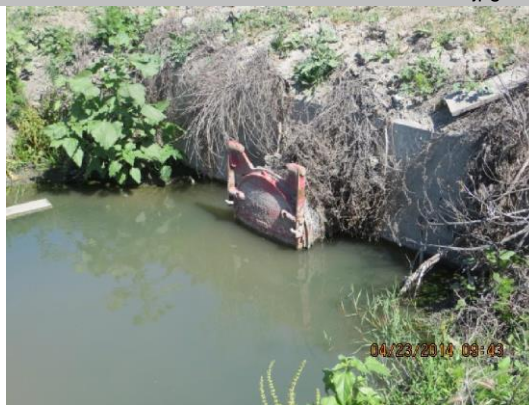
Photo 2 of 3 : UCIP\_SP\_2017\_34656\_62447.jpg

LM Start	<b>14.46</b>	Rating **	A/W	Issue No.	<b>1343 (cont)</b>
LM End	<b>14.46</b>	Issue Type +	Ma	Location *	LS

Headwall, pipe, and flapgate on WS toe.

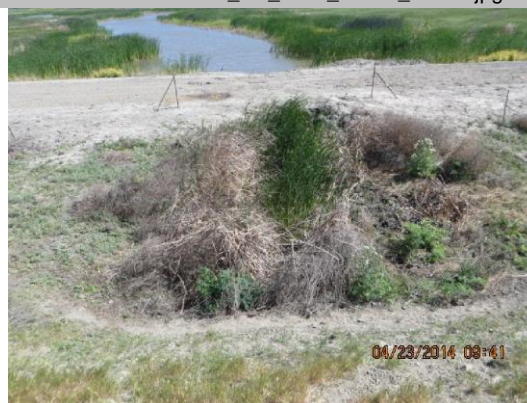
Photo 3 of 3 : UCIP\_SP\_2017\_34656\_62445.jpg

LM Start	14.46	Rating **	A/W	Issue No.	1343 (cont)
LM End	14.46	Issue Type +	Ma	Location *	LS
Category	Supplemental			GPS Latitude/Longitude	
				Start	End
Item	DWR UCIP LMA Responsibility			37.162722 °	37.162722 °
				-120.618571 °	-120.618571 °
DWR ID					
Comment Code					
Inspector Comment					
FS_ID:34656					
DS_ID:19711					
EP_NO: N/A					
Repair Type: No Action Needed					
Crossing Status: Found					
UCIP Comments:					
FIELD_STRUCT_DESC: 24-inch C.M. stormdrain pipe through the					
levee, 12.5-feet below the crown. Flap gate on the waterward end.					
Concrete headwall on each end. Concrete weir inlet structure on LS toe					
(USACE-1967). This entry matches the Drainage or Irrigation Structure					
referenced in O&M manual (HLM 14.44).					
FS Date: 4/23/2014

Concrete weir inlet at LS toe.

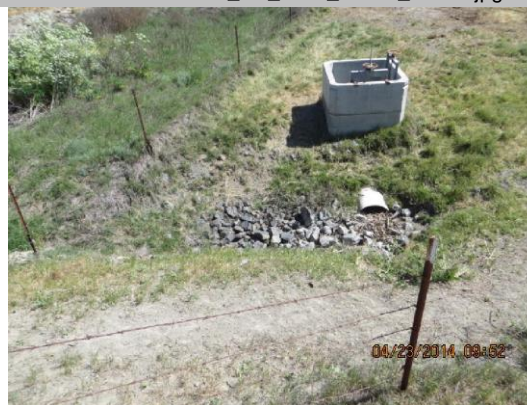
Photo 1 of 3 : UCIP\_SP\_2017\_34664\_62454.jpg

LM Start	15.11	Rating **	M	Issue No.	1344
LM End	15.11	Issue Type +	Ma	Location *	LS
Category	Supplemental			GPS Latitude/Longitude	
				Start	End
Item	DWR UCIP LMA Responsibility			37.156805 °	37.156805 °
				-120.609513 °	-120.609513 °
DWR ID					
Comment Code					
Inspector Comment					
FS_ID:34664					
DS_ID:19712					
EP_NO: N/A					
Repair Type: Non-Urgent					
Crossing Status: Found					
UCIP Comments: Minor erosion at headwall on WS toe.					
FIELD_STRUCT_DESC: 36-inch C.M. stormdrain pipe through the					
levee, 11.9 feet below the crown. Flap gate on the waterward end.					
Concrete headwall on both ends. (USACE-1967). This entry matches					
the Drainage or Irrigation Structure referenced in O&M manual (HLM					
15.09).					
FS Date: 4/23/2014

Headwall and inlet on LS toe.

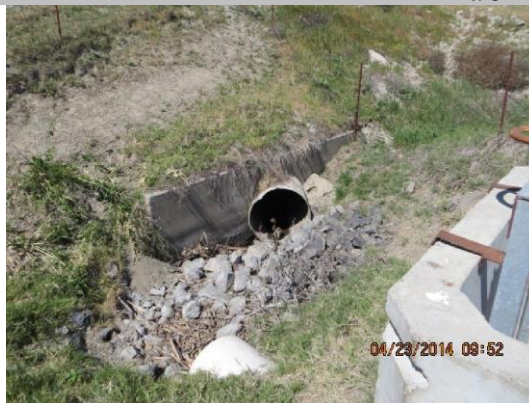
Photo 2 of 3 : UCIP\_SP\_2017\_34664\_62453.jpg

LM Start	15.11	Rating **	M	Issue No.	1344 (cont)	
LM End	15.11	Issue Type +	Ma	Location *	LS	
Category	Supplemental			GPS Latitude/Longitude		
				Start		End
Item	DWR UCIP LMA Responsibility			37.156805 °		37.156805 °
				-120.609513 °		-120.609513 °
DWR ID						
Comment Code						
Inspector Comment						
FS_ID:34664 DS_ID:19712 EP_NO: N/A Repair Type: Non-Urgent Crossing Status: Found UCIP Comments: Minor erosion at headwall on WS toe. FIELD_STRUCT_DESC: 36-inch C.M. stormdrain pipe through the levee, 11.9 feet below the crown. Flap gate on the waterward end. Concrete headwall on both ends. (USACE-1967). This entry matches the Drainage or Irrigation Structure referenced in O&M manual (HLM 15.09). FS Date: 4/23/2014

Headwall and inlet on LS toe.

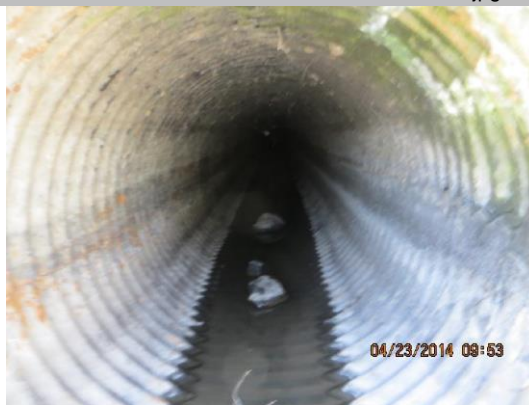
Photo 3 of 3 : UCIP\_SP\_2017\_34664\_62452.jpg

LM Start	15.11	Rating **	M	Issue No.	1344 (cont)
LM End	15.11	Issue Type +	Ma	Location *	LS

Inside pipe at LS toe.

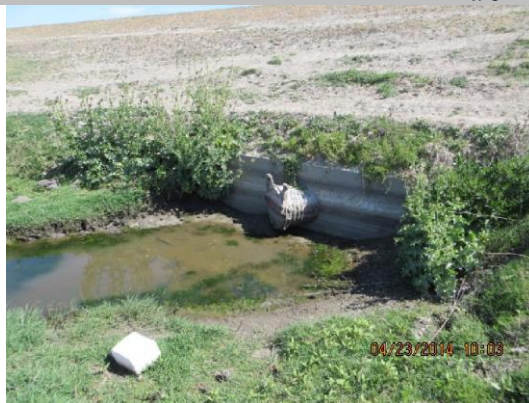
Photo 1 of 3 : UCIP\_SP\_2017\_39595\_62459.jpg

LM Start	15.76	Rating **	M	Issue No.	1345
LM End	15.76	Issue Type +	En	Location *	LS
Category	Supplemental			GPS Latitude/Longitude	
				Start	End
Item	DWR UCIP Field Study			37.150012 °	37.150012 °
				-120.601330 °	-120.601330 °
DWR ID					
Comment Code					
Inspector Comment					
FS_ID:39595 DS_ID:19713 EP_NO: N/A Repair Type: Non-Urgent Crossing Status: Found UCIP Comments: Sediment buildup in pipe visible from landward side--recommend contacting owner to clear pipe. FIELD_STRUCT_DESC: 24-inch C.M. Stormdrain pipe through the levee, 11.0 feet below the crown. Flap gate on the waterward end. Concrete headwalls on both ends. (USACE-1967). This entry matches the Drainage or Irrigation Structure referenced in O&M manual (HLM 15.74). FS Date: 4/23/2014

Headwall, pipe, and flapgate on WS toe.

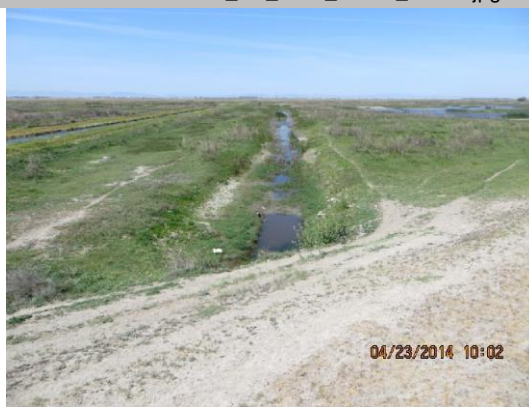
Photo 2 of 3 : UCIP\_SP\_2017\_39595\_62456.jpg

Headwall, pipe, and flapgate on WS toe.

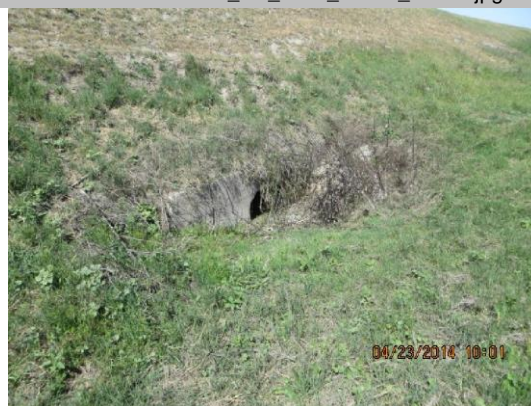
Photo 3 of 3 : UCIP\_SP\_2017\_39595\_62458.jpg

LM Start	15.76	Rating **	M	Issue No.	1345 (cont)	
LM End	15.76	Issue Type +	En	Location *	LS	
Category	Supplemental			GPS Latitude/Longitude		
				Start		End
Item	DWR UCIP Field Study			37.150012 °		37.150012 °
				-120.601330 °		-120.601330 °
DWR ID						
Comment Code						
Inspector Comment						
FS_ID:39595 DS_ID:19713 EP_NO: N/A Repair Type: Non-Urgent Crossing Status: Found UCIP Comments: Sediment buildup in pipe visible from landward side--recommend contacting owner to clear pipe. FIELD_STRUCT_DESC: 24-inch C.M. Stormdrain pipe through the levee, 11.0 feet below the crown. Flap gate on the waterward end. Concrete headwalls on both ends. (USACE-1967). This entry matches the Drainage or Irrigation Structure referenced in O&M manual (HLM 15.74). FS Date: 4/23/2014

Headwall and pipe at LS toe.

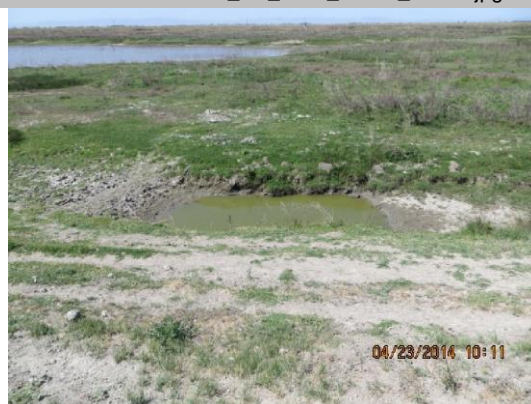
Photo 1 of 3 : UCIP\_SP\_2017\_39596\_62464.jpg

LM Start	15.81	Rating **	M	Issue No.	1346
LM End	15.81	Issue Type +	Ma	Location *	LS
Category	Supplemental			GPS Latitude/Longitude	
				Start	End
Item	DWR UCIP LMA Responsibility			37.149381 °	37.149381 °
				-120.600761 °	-120.600761 °
DWR ID					
Comment Code					
Inspector Comment					
FS_ID:39596 DS_ID:19715 EP_NO: N/A Repair Type: Non-Urgent Crossing Status: Found UCIP Comments: Excess vegetation at inlet on LS toe should be cleared. FIELD_STRUCT_DESC: 24-inch C.M. stormdrain pipe through the levee, 12-feet below the crown. Flap gate on the waterward end. Concrete head wall on the landward end. Concrete saddle and apron on the waterward end. (USACE-1967). This entry matches the Drainage or Irrigation Structure referenced in O&M manual (HLM 15.80). FS Date: 4/23/2014

Headwall, pipe, and flapgate on WS toe.

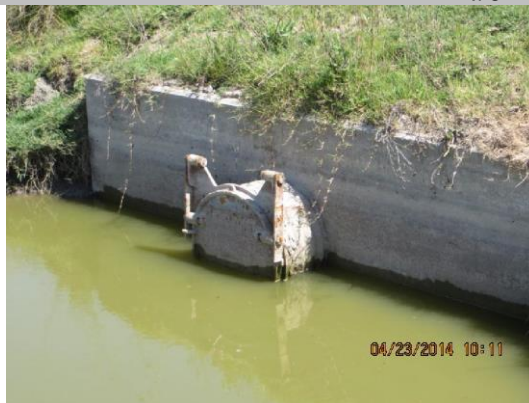
Photo 2 of 3 : UCIP\_SP\_2017\_39596\_62467.jpg

LM Start	15.81	Rating **	M	Issue No.	1346 (cont)	
LM End	15.81	Issue Type +	Ma	Location *	LS	
Category	Supplemental			GPS Latitude/Longitude		
				Start		End
Item	DWR UCIP LMA Responsibility			37.149381 °		37.149381 °
				-120.600761 °		-120.600761 °
DWR ID						
Comment Code						
Inspector Comment						
FS_ID:39596						
DS_ID:19715						
EP_NO: N/A						
Repair Type: Non-Urgent						
Crossing Status: Found						
UCIP Comments: Excess vegetation at inlet on LS toe should be cleared.						
FIELD_STRUCT_DESC: 24-inch C.M. stormdrain pipe through the levee, 12-feet below the crown. Flap gate on the waterward end. Concrete head wall on the landward end. Concrete saddle and apron on the waterward end. (USACE-1967). This entry matches the Drainage or Irrigation Structure referenced in O&M manual (HLM 15.80).						
FS Date: 4/23/2014

Headwall, pipe, and flapgate on WS toe.

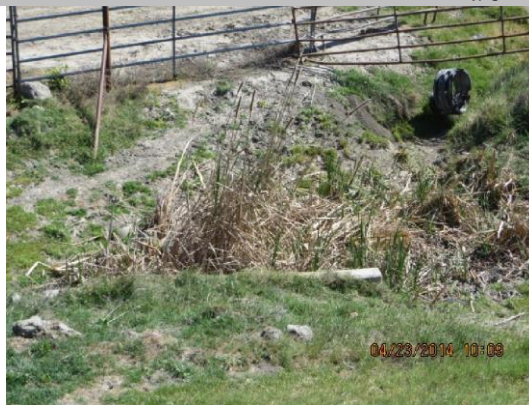
Photo 3 of 3 : UCIP\_SP\_2017\_39596\_62466.jpg

LM Start	<b>15.81</b>	Rating **	M	Issue No.	<b>1346 (cont)</b>
LM End	<b>15.81</b>	Issue Type +	Ma	Location *	LS

Headwall and pipe visible at LS toe.

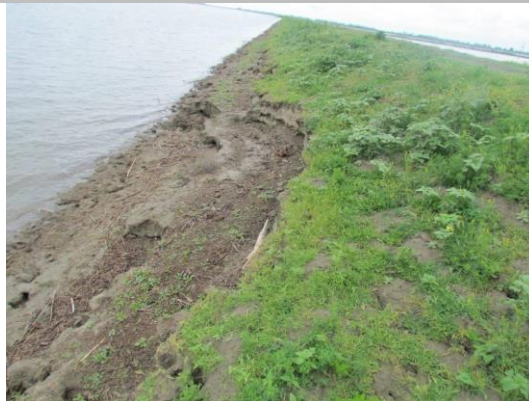
Photo 1 of 2 : SP\_2017\_NA0010\_123\_110\_20170424\_00285.jpg

LM Start	16.11	Rating **	U	Issue No.	110
LM End	16.36	Issue Type +	Ma	Location *	WS
Category	Earthen Levee			GPS Latitude/Longitude	
				Start	End
Item	Erosion / Bank Caving			37.145965 °	37.142963 °
				-120.597597 °	-120.595087 °
DWR ID	DWR_NA0010_05_s_2017_110				
Comment Code					
E2 : Schedule repair of erosion site prior to the next inspection.					
Inspector Comment					
Eight to ten inch erosion on waterward toe.

Looking upstream at erosion on waterward slope.

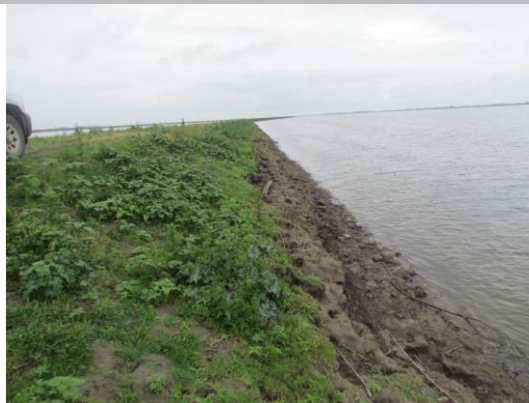
Photo 2 of 2 : SP\_2017\_NA0010\_123\_110\_20170424\_00286.jpg

Looking downstream at erosion on waterward slope.

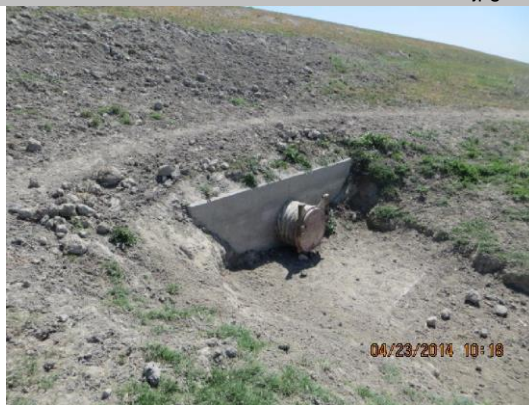
Photo 2 of 3 : UCIP\_SP\_2017\_34725\_62471.jpg

LM Start	16.68	Rating **	M	Issue No.	1347
LM End	16.68	Issue Type +	Ma	Location *	WS
Category	Supplemental			GPS Latitude/Longitude	
				Start	End
Item	DWR UCIP LMA Responsibility			37.138760 °	37.138760 °
				-120.592393 °	-120.592393 °
DWR ID					
Comment Code					
Inspector Comment					
FS_ID:34725 DS_ID:19716 EP_NO: N/A Repair Type: Non-Urgent Crossing Status: Found UCIP Comments: Pipe heavily silted on LS toe. FIELD_STRUCT_DESC: 24-inch C.M. stormdrain pipe through the levee, 10.5-feet below the crown. Flap gate on the waterward end. Concrete headwall on both ends. (USACE-1967). This entry matches the Drainage or Irrigation Structure referenced in O&M manual (HLM 16.67). FS Date: 4/23/2014

Headwall, flapgate, and pipe visible on WS toe.

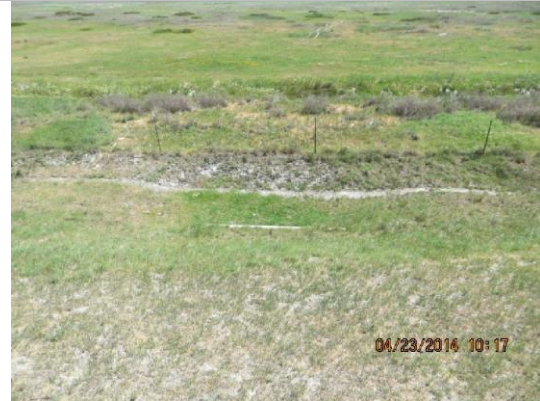
Photo 3 of 3 : UCIP\_SP\_2017\_34725\_62470.jpg

LM Start	16.68	Rating **	M	Issue No.	1347 (cont)
LM End	16.68	Issue Type +	Ma	Location *	WS
Category	Supplemental			GPS Latitude/Longitude	
				Start	End
Item	DWR UCIP LMA Responsibility			37.138760 °	37.138760 °
				-120.592393 °	-120.592393 °
DWR ID					
Comment Code					
Inspector Comment					
FS_ID:34725 DS_ID:19716 EP_NO: N/A Repair Type: Non-Urgent Crossing Status: Found UCIP Comments: Pipe heavily silted on LS toe. FIELD_STRUCT_DESC: 24-inch C.M. stormdrain pipe through the levee, 10.5-feet below the crown. Flap gate on the waterward end. Concrete headwall on both ends. (USACE-1967). This entry matches the Drainage or Irrigation Structure referenced in O&M manual (HLM 16.67). FS Date: 4/23/2014

Concrete headwall and pipe visible on LS toe.

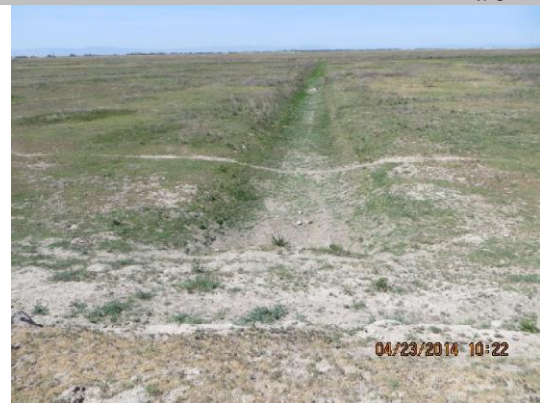
Photo 1 of 3 : UCIP\_SP\_2017\_39597\_62481.jpg

LM Start	17.22	Rating **	M	Issue No.	1348
LM End	17.22	Issue Type +	Ma	Location *	WS
Category	Supplemental			GPS Latitude/Longitude	
				Start	End
Item	DWR UCIP LMA Responsibility			37.132211 °	37.132211 °
				-120.587106 °	-120.587106 °
DWR ID					
Comment Code					
Inspector Comment					
FS_ID:39597					
DS_ID:19717					
EP_NO: N/A					
Repair Type: Non-Urgent					
Crossing Status: Found					
UCIP Comments: Sediment buildup in pipe visible from landward side--recommend contacting owner to clear pipe.					
FIELD_STRUCT_DESC: 24-inch CM stormdrain pipe through the levee, 12-feet below the crown. Flap gate on the waterward end. Concrete headwall on both ends. (USACE-1967). This entry matches the Drainage or Irrigation Structure referenced in O&M manual (HLM 17.20).					
FS Date: 4/23/2014

Headwall, flapgate, and pipe visible on WS toe.

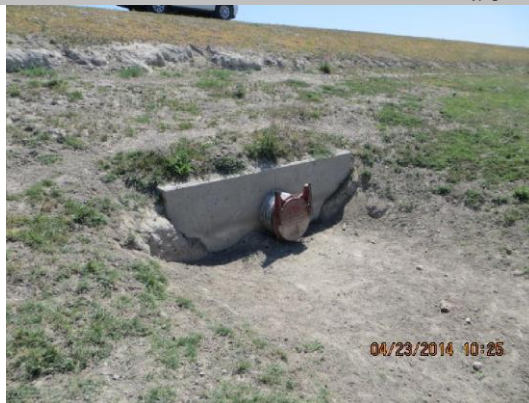
Photo 2 of 3 : UCIP\_SP\_2017\_39597\_62483.jpg

LM Start	17.22	Rating **	M	Issue No.	1348 (cont)
LM End	17.22	Issue Type +	Ma	Location *	WS
Category	Supplemental			GPS Latitude/Longitude	
				Start	End
Item	DWR UCIP LMA Responsibility			37.132211 °	37.132211 °
				-120.587106 °	-120.587106 °
DWR ID					
Comment Code					
Inspector Comment					
FS_ID:39597					
DS_ID:19717					
EP_NO: N/A					
Repair Type: Non-Urgent					
Crossing Status: Found					
UCIP Comments: Sediment buildup in pipe visible from landward side--recommend contacting owner to clear pipe.					
FIELD_STRUCT_DESC: 24-inch CM stormdrain pipe through the levee, 12-feet below the crown. Flap gate on the waterward end. Concrete headwall on both ends. (USACE-1967). This entry matches the Drainage or Irrigation Structure referenced in O&M manual (HLM 17.20).					
FS Date: 4/23/2014

Headwall, flapgate, and pipe visible on WS toe.

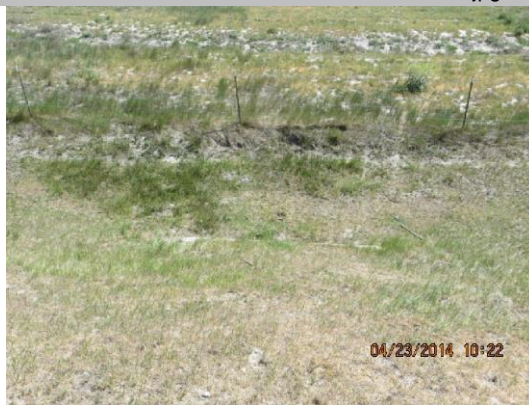
Photo 3 of 3 : UCIP\_SP\_2017\_39597\_62482.jpg

LM Start	17.22	Rating **	M	Issue No.	1348 (cont)
LM End	17.22	Issue Type +	Ma	Location *	WS

Headwall and pipe visible on LS toe.

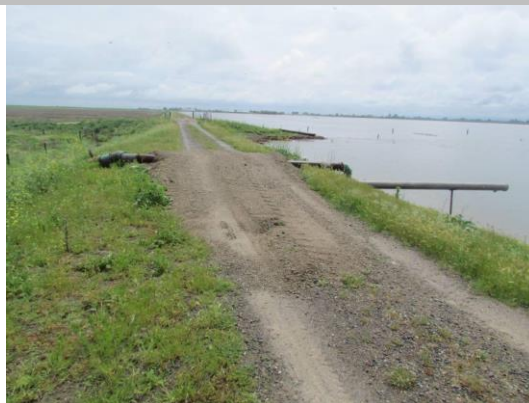
Photo 1 of 1 : SP\_2017\_NA0010\_123\_111\_20170424\_00287.jpg

LM Start	17.50	Rating **	U	Issue No.	111
LM End	17.50	Issue Type +	En	Location *	CR
Category	Earthen Levee			GPS Latitude/Longitude	
				Start	End
Item	Encroachments			37.128410 °	37.128410 °
				-120.585482 °	-120.585482 °
DWR ID	DWR_NA0010_05_s_2017_111				
Comment Code					
PI : Pipe					
Inspector Comment					
Eight inch drain pipe across levee. Two locations

Looking upstream at irrigation pipe across levee crown.

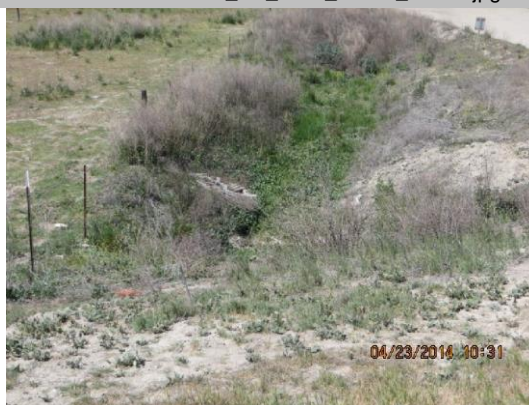
Photo 1 of 3 : UCIP\_SP\_2017\_39599\_62485.jpg

LM Start	17.54	Rating **	M	Issue No.	1349
LM End	17.54	Issue Type +	Ma	Location *	CR
Category	Supplemental			GPS Latitude/Longitude	
				Start	End
Item	DWR UCIP LMA Responsibility			37.127843 °	37.127843 °
				-120.585245 °	-120.585245 °
DWR ID					
Comment Code					
Inspector Comment					
FS_ID:39599 DS_ID:19743 EP_NO: N/A Repair Type: Non-Urgent Crossing Status: Found UCIP Comments: Sediment buildup in pipe visible from landward side-- recommend contacting owner to clear pipe. FIELD_STRUCT_DESC: 24-inch CM stormdrain pipe through the levee, 9.8-feet below the crown. Flap gate on the waterward end. Concrete headwall on both ends. (USACE-1967). This entry matches the Drainage or Irrigation Structure referenced in O&M manual (HLM 17.52). FS Date: 4/23/2014

Headwall, pipe, and flapgate visible on WS toe.

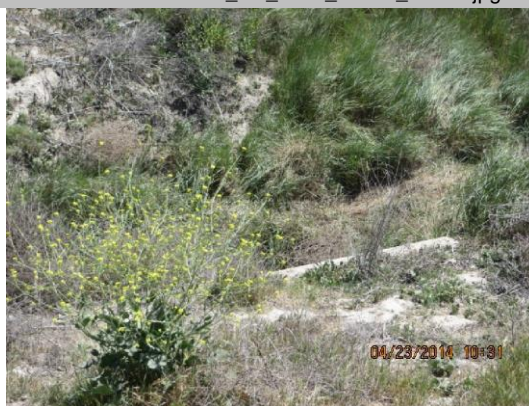
Photo 2 of 3 : UCIP\_SP\_2017\_39599\_62486.jpg

LM Start	17.54	Rating **	M	Issue No.	1349 (cont)
LM End	17.54	Issue Type +	Ma	Location *	CR
Category	Supplemental			GPS Latitude/Longitude	
				Start	End
Item	DWR UCIP LMA Responsibility			37.127843 °	37.127843 °
				-120.585245 °	-120.585245 °
DWR ID					
Comment Code					
Inspector Comment					
FS_ID:39599 DS_ID:19743 EP_NO: N/A Repair Type: Non-Urgent Crossing Status: Found UCIP Comments: Sediment buildup in pipe visible from landward side--recommend contacting owner to clear pipe. FIELD_STRUCT_DESC: 24-inch CM stormdrain pipe through the levee, 9.8-feet below the crown. Flap gate on the waterward end. Concrete headwall on both ends. (USACE-1967). This entry matches the Drainage or Irrigation Structure referenced in O&M manual (HLM 17.52). FS Date: 4/23/2014

Pipe and headwall visible on LS toe.

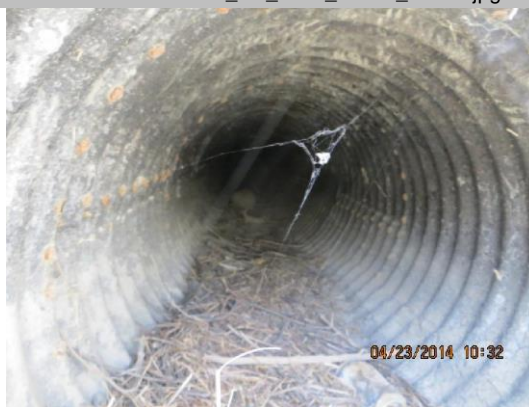
Photo 3 of 3 : UCIP\_SP\_2017\_39599\_62488.jpg

LM Start	<b>17.54</b>	Rating **	M	Issue No.	<b>1349 (cont)</b>
LM End	<b>17.54</b>	Issue Type +	Ma	Location *	CR

Inside pipe on LS toe.
