**Flood Control Project Maintenance  
Levee Inspections**  
**LMA District Cover Sheet**  
**Spring 2017 Levee Inspection Results**

**Lower San Joaquin Levee District**

Waterway			Bank	Unit Miles
Unit No. 01 San Joaquin River			Right	22.52
	Spring (March - May)	Summer (June - August)	(September - November) Fall	Winter (December - February)
Unit Maintenance Rating (Fall Only)				
Date of Inspection	4/17/2017 - 4/20/2017			
DWR Inspector	Richard Willoughby			
Accompanied By

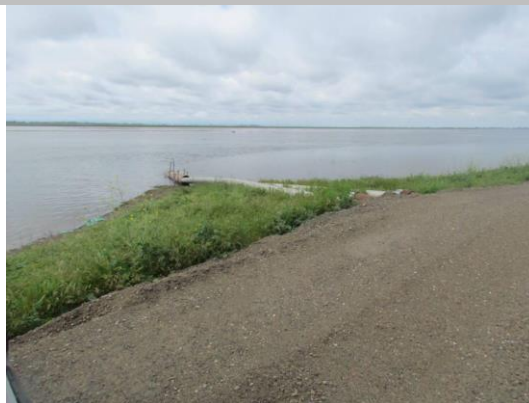
Photo 1 of 2 : SP\_2017\_NA0010\_123\_112\_20170424\_00288.jpg

LM Start	18.06	Rating **	U	Issue No.	112
LM End	18.06	Issue Type +	En	Location *	CR
Category	Earthen Levee			GPS Latitude/Longitude	
				Start	End
Item	Encroachments			37.120690 °	37.120690 °
				-120.582218 °	-120.582218 °
DWR ID	DWR_NA0010_05_s_2017_112				
Comment Code					
PI : Pipe					
Inspector Comment					
Temporary eight inch (3) pipes across levee crown on both slopes.

Looking at temporary pipe on waterward slope.

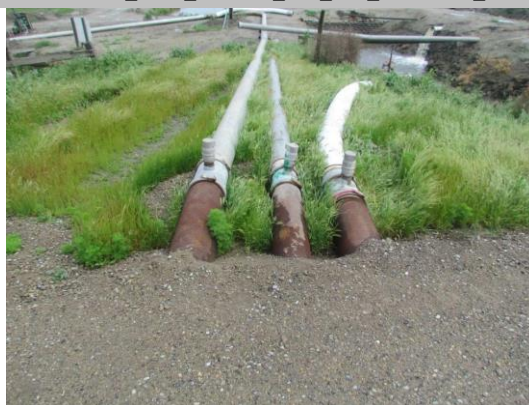
Photo 2 of 2 : SP\_2017\_NA0010\_123\_112\_20170424\_00289.jpg

LM Start	<b>18.06</b>	Rating **	U	Issue No.	<b>112 (cont)</b>
LM End	<b>18.06</b>	Issue Type +	En	Location *	CR

Looking at three temporary pipes on landward slope.

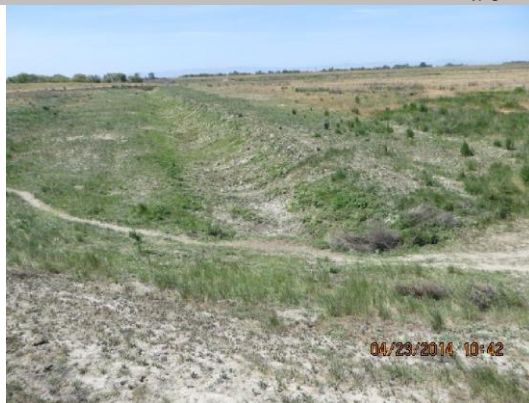
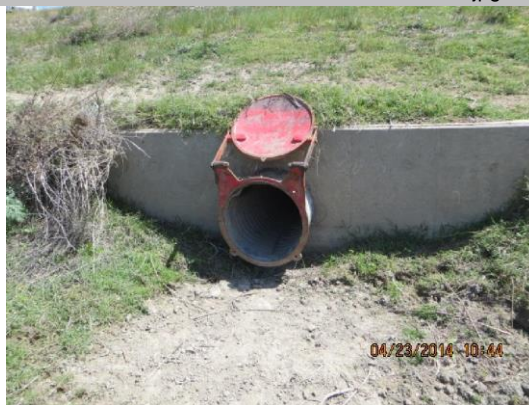
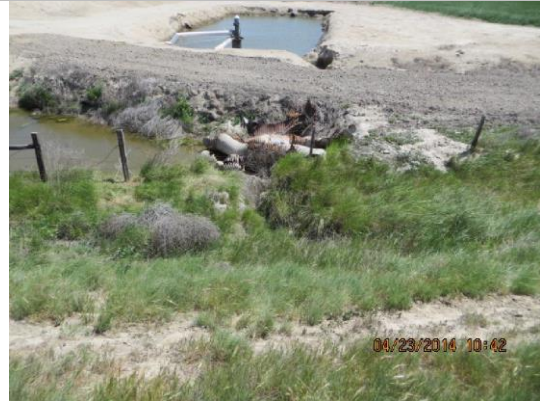
LM Start	18.09	Rating **	M	Issue No.	1350
LM End	18.09	Issue Type +	Ma	Location *	CR
Category	Supplemental			GPS Latitude/Longitude	
				Start	End
Item	DWR UCIP LMA Responsibility			37.120309 °	37.120309 °
				-120.582041 °	-120.582041 °
DWR ID					
Comment Code					
Inspector Comment					
FS_ID:34747 DS_ID:19745 EP_NO: N/A Repair Type: Non-Urgent Crossing Status: Found UCIP Comments: Animal burrows in levee on both slopes. FIELD_STRUCT_DESC: 24-inch C.M. stormdrain pipe through the levee, 12.4-feet below the crown. Flap gate on the waterward end. Concrete headwall on both ends. (USACE-1967). This entry matches the Drainage or Irrigation Structure referenced in O&M manual (HLM 18.07). FS Date: 4/23/2014

Headwall, pipe, and flapgate on WS toe.

Headwall and pipe visible on LS toe.

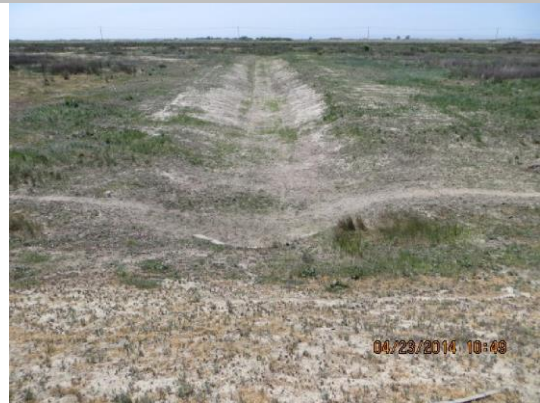
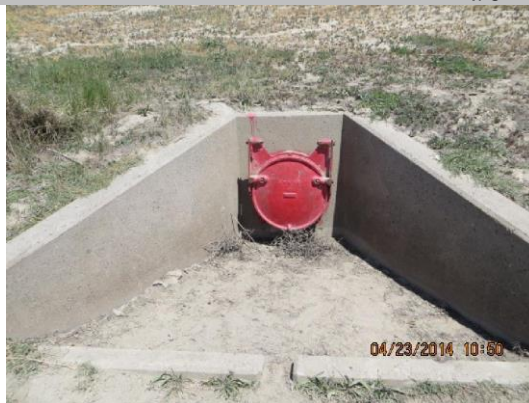
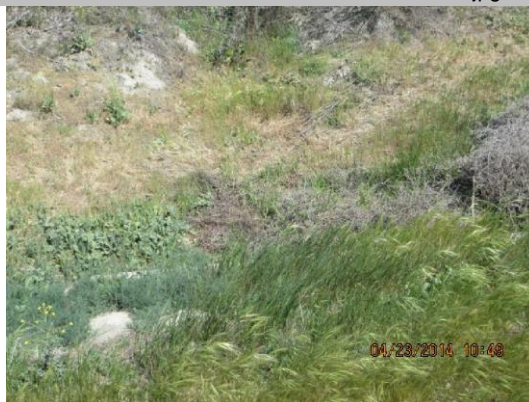
LM Start	18.70	Rating **	M	Issue No.	1351
LM End	18.70	Issue Type +	Ma	Location *	CR
Category	Supplemental			GPS Latitude/Longitude	
				Start	End
Item	DWR UCIP LMA Responsibility			37.115472 °	37.115472 °
				-120.573628 °	-120.573628 °
DWR ID

Comment Code					
Inspector Comment					
FS_ID:39600 DS_ID:19746 EP_NO: N/A Repair Type: Non-Urgent Crossing Status: Found UCIP Comments: Dense vegetation limits the inspector's visibility to identify signs of pipe failure (leaks) along the landward slope. Recommend removing vegetation along pipe alignment to conduct proper inspection of structure. FIELD_STRUCT_DESC: 24-inch C.M. stormdrain pipe through the levee, 10.0-feet below the crown. Flap gate on the waterward end. Concrete headwall on the landward end. Concrete "U" headwall on the waterward end. (USACE-1967). This entry matches the Drainage or Irrigation Structure referenced in O&M manual (HLM 18.68). FS Date: 4/23/2014

Headwall, pipe and flapgate visible on WS toe.

Headwall and pipe on LS toe.

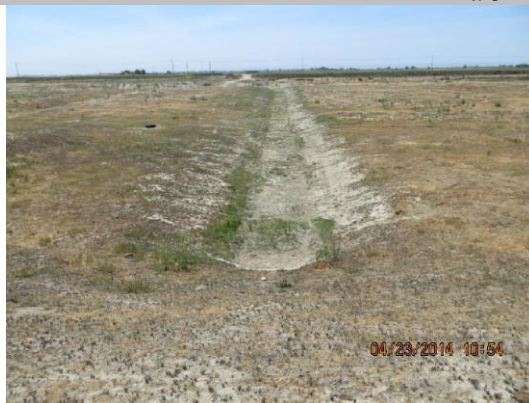
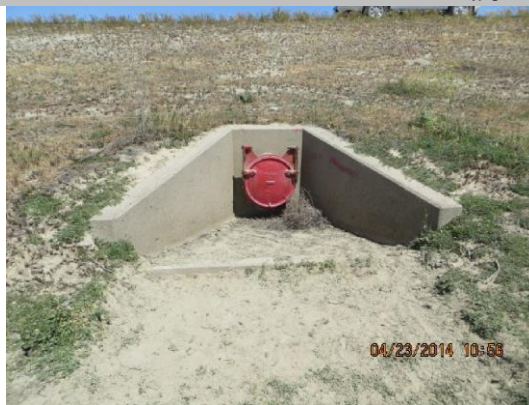
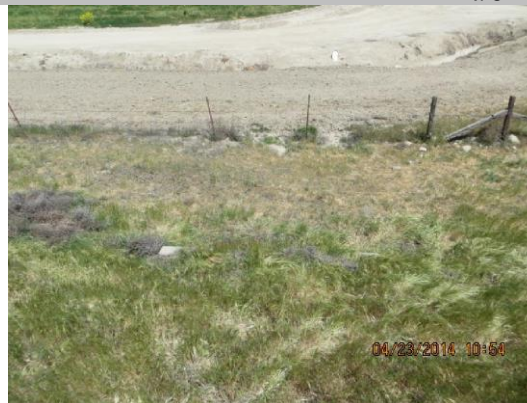
LM Start	19.15	Rating **	M	Issue No.	1352
LM End	19.15	Issue Type +	Ma	Location *	CR
Category	Supplemental			GPS Latitude/Longitude	
				Start	End
Item	DWR UCIP LMA Responsibility			37.115466 °	37.115466 °
				-120.565467 °	-120.565467 °
DWR ID					
Comment Code					
Inspector Comment					
FS_ID:39601 DS_ID:19747 EP_NO: N/A Repair Type: Non-Urgent Crossing Status: Found UCIP Comments: Sediment buildup in pipe visible from landward side--recommend contacting owner to clear pipe. FIELD_STRUCT_DESC: 24-inch C.M. stormdrain pipe through the levee, 10.0-feet below the crown. Flap gate on the waterward end. Concrete headwall on the landward end. Concrete "U" headwall on the waterward end. (USACE-1967). This entry matches the Drainage or Irrigation Structure referenced in O&M manual (HLM 19.11). FS Date: 4/23/2014

Headwall, pipe, and flapgate visible on WS toe.

Headwall and pipe visible on LS toe.

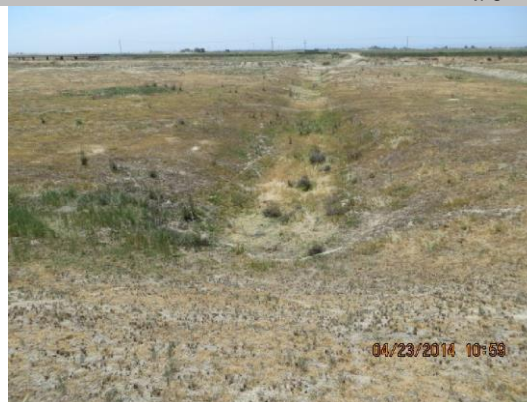
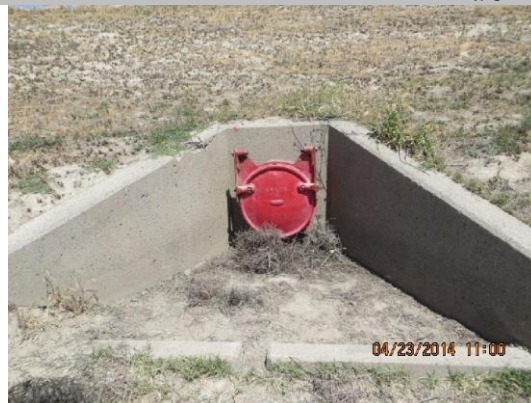
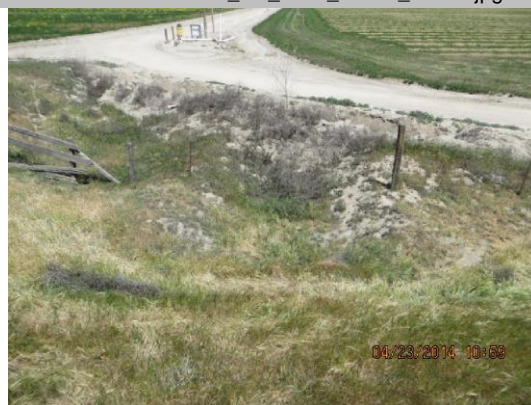
LM Start	19.17	Rating **	A/W	Issue No.	1353
LM End	19.17	Issue Type +	Ma	Location *	CR
Category	Supplemental			GPS Latitude/Longitude	
				Start	End
Item	DWR UCIP LMA Responsibility			37.115463 °	37.115463 °
				-120.565086 °	-120.565086 °
DWR ID					
Comment Code					
Inspector Comment					
FS_ID:34751					
DS_ID:19776					
EP_NO: N/A					
Repair Type: No Action Needed					
Crossing Status: Found					
UCIP Comments:					
FIELD_STRUCT_DESC: 24-inch C.M. stormdrain pipe through the levee, 10.3-feet below the crown. Flap gate on the waterward end. Concrete headwall on the landward end. Concrete "U" headwall on the waterward end. (USACE-1967). This entry matches the Drainage or Irrigation Structure referenced in O&M manual (HLM 19.15).					
FS Date: 4/23/2014

Headwall, pipe, and flapgate visible on WS toe.

Headwall and pipe visible on LS toe.

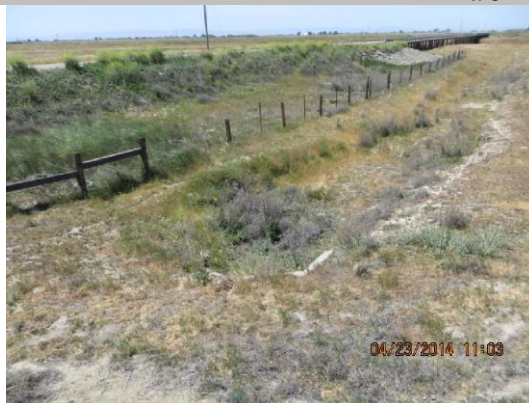
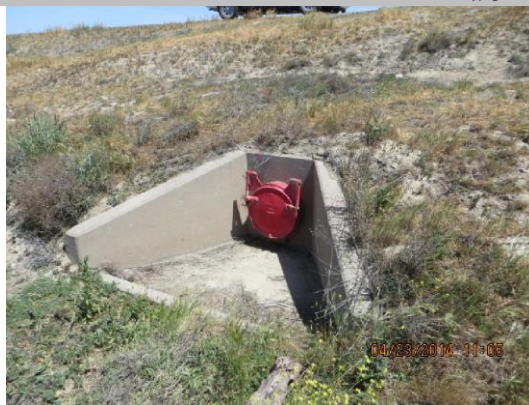
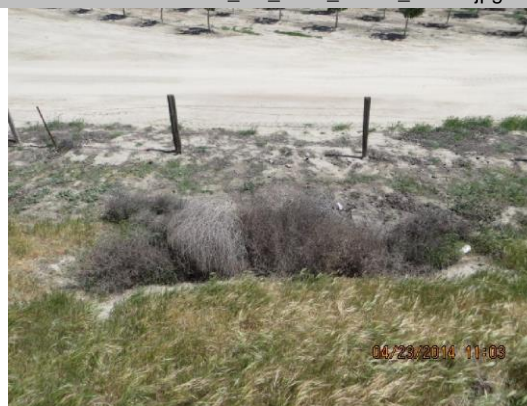
LM Start	19.48	Rating **	M	Issue No.	1354
LM End	19.48	Issue Type +	Ma	Location *	CR
Category	Supplemental			GPS Latitude/Longitude	
				Start	End
Item	DWR UCIP LMA Responsibility			37.113542 °	37.113542 °
				-120.560389 °	-120.560389 °
DWR ID					
Comment Code					
Inspector Comment					
FS_ID:39602 DS_ID:19777 EP_NO: N/A Repair Type: Non-Urgent Crossing Status: Found UCIP Comments: Sediment buildup in pipe visible from landward side-- recommend contacting owner to clear pipe. FIELD_STRUCT_DESC: 24-inch C.M. stormdrain pipe through the levee, 9.0-feet below the crown. Flap gate on the waterward end. Concrete headwall on the landward end. Concrete "U" headwall on the waterward end. (USACE-1967). This entry matches the Drainage or Irrigation Structure referenced in O&M manual (HLM 19.46). FS Date: 4/23/2014

Headwall, pipe, and flapgate visible on WS toe.

Headwall and pipe visible on LS toe.

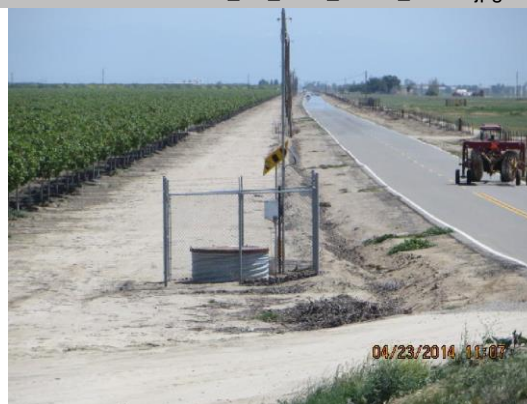
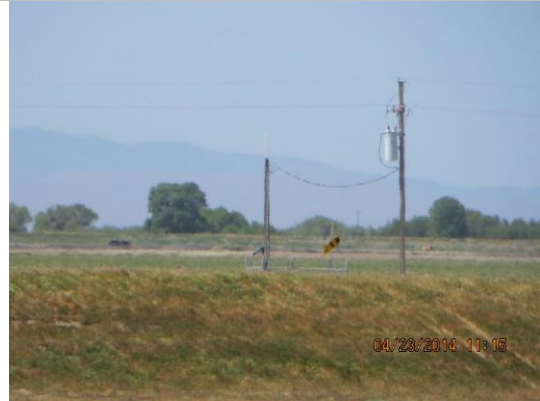
LM Start	19.51	Rating **	M	Issue No.	1355
LM End	19.51	Issue Type +	En	Location *	CR
Category	Supplemental			GPS Latitude/Longitude	
				Start	End
Item	DWR UCIP Field Study			37.113172 °	37.113172 °
				-120.560014 °	-120.560014 °
DWR ID					
Comment Code					
Inspector Comment					
FS_ID:39345 DS_ID:24868 EP_NO: N/A Repair Type: Non-Urgent Crossing Status: Indicator Found UCIP Comments: Markers closer to the levee may be necessary to properly mark pipe crossing location. FIELD_STRUCT_DESC: Gasline of unknown diameter at unknown depth below the crown. CMP riser and gasline marker off LS toe. FS Date: 4/22/2014

Gasline marker off LS toe.

Gasline marker off LS of opposite bank.

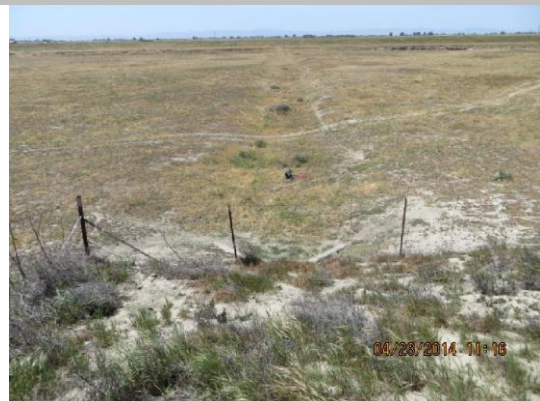
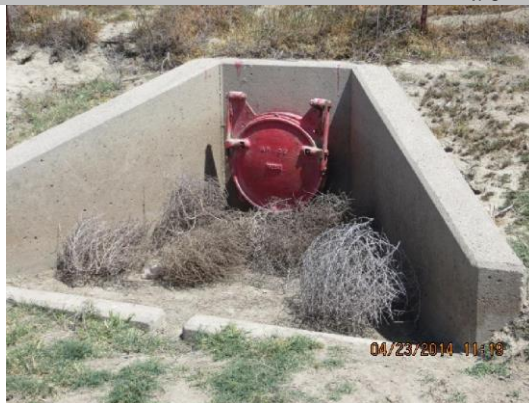
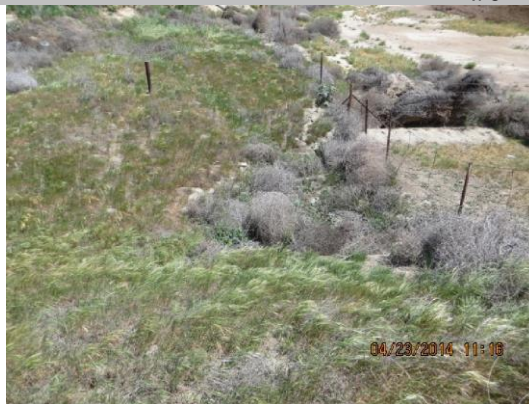
LM Start	19.52	Rating **	M	Issue No.	1356
LM End	19.52	Issue Type +	Ma	Location *	CR
Category	Supplemental			GPS Latitude/Longitude	
				Start	End
Item	DWR UCIP LMA Responsibility			37.112953 °	37.112953 °
				-120.559943 °	-120.559943 °
DWR ID

Comment Code					
Inspector Comment					
FS_ID:39603 DS_ID:19778 EP_NO: N/A Repair Type: Non-Urgent Crossing Status: Found UCIP Comments: Dense vegetation limits the inspector's visibility to identify signs of pipe failure (leaks) along the landward slope. Recommend removing vegetation along pipe alignment to conduct proper inspection of structure. Sediment buildup in pipe visible from landward side--recommend contacting owner to clear pipe. FIELD_STRUCT_DESC: 24-inch C.M. stormdrain pipe through the levee, 9.7 feet below the crown. Flap gate on the waterward end. Concrete headwall on the landward end. Concrete "U" headwall on the waterward end. (USACE-1967). This entry matches the Drainage or Irrigation Structure referenced in O&M manual (HLM 19.50). FS Date: 4/23/2014

Headwall, pipe, and flapgate visible on WS toe.

Headwall and pipe visible on LS toe.

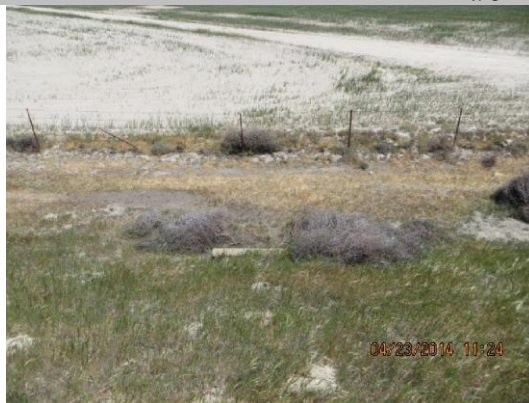
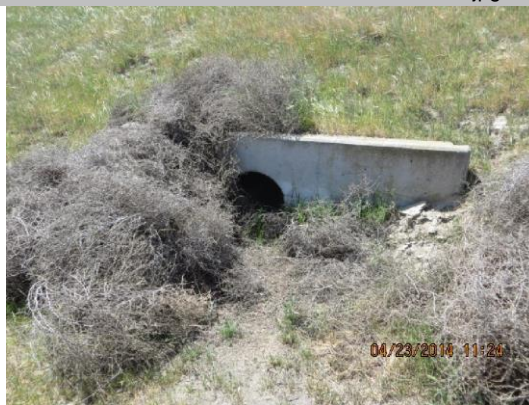
LM Start	19.86	Rating **	A/W	Issue No.	1357
LM End	19.86	Issue Type +	Ma	Location *	CR
Category	Supplemental			GPS Latitude/Longitude	
				Start	End
Item	DWR UCIP LMA Responsibility			37.109284 °	37.109284 °
				-120.555948 °	-120.555948 °
DWR ID					
Comment Code					
Inspector Comment					
FS_ID:34754 DS_ID:19779 EP_NO: N/A Repair Type: No Action Needed Crossing Status: Found UCIP Comments: FIELD_STRUCT_DESC: 24-inch C.M. stormdrain pipe through the levee, 10.3-feet below the crown. Flap gate on the waterward end. Concrete headwall on the landward end. Concrete "U" headwall on the waterward end. (USACE-1967). This entry matches the Drainage or Irrigation Structure referenced in O&M manual (HLM 19.84). FS Date: 4/23/2014

Headwall and pipe visible on LS toe.

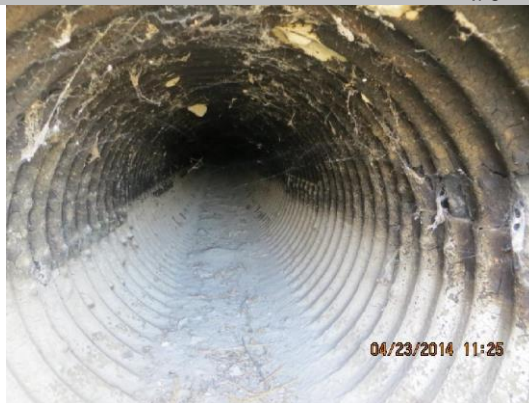
Photo 3 of 3 : UCIP\_SP\_2017\_34754\_62523.jpg

LM Start	19.86	Rating **	A/W	Issue No.	1357 (cont)
LM End	19.86	Issue Type +	Ma	Location *	CR
Category	Supplemental			GPS Latitude/Longitude	
				Start	End
Item	DWR UCIP LMA Responsibility			37.109284 °	37.109284 °
				-120.555948 °	-120.555948 °
DWR ID					
Comment Code					
Inspector Comment					
FS_ID:34754 DS_ID:19779 EP_NO: N/A Repair Type: No Action Needed Crossing Status: Found UCIP Comments: FIELD_STRUCT_DESC: 24-inch C.M. stormdrain pipe through the levee, 10.3-feet below the crown. Flap gate on the waterward end. Concrete headwall on the landward end. Concrete "U" headwall on the waterward end. (USACE-1967). This entry matches the Drainage or Irrigation Structure referenced in O&M manual (HLM 19.84). FS Date: 4/23/2014

Inside pipe on LS toe.

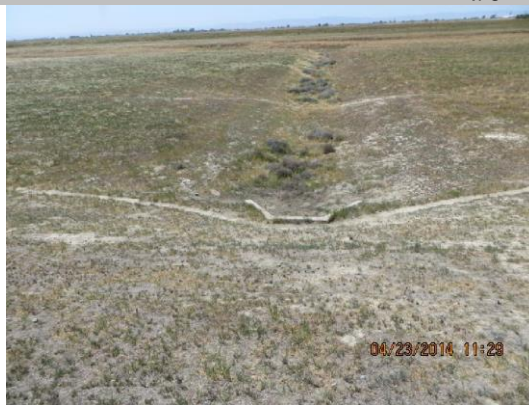
Photo 1 of 3 : UCIP\_SP\_2017\_34755\_62529.jpg

LM Start	19.94	Rating **	A/W	Issue No.	1358
LM End	19.94	Issue Type +	Ma	Location *	CR
Category	Supplemental			GPS Latitude/Longitude	
				Start	End
Item	DWR UCIP LMA Responsibility			37.108426 °	37.108426 °
				-120.554990 °	-120.554990 °
DWR ID					
Comment Code					
Inspector Comment					
FS_ID:34755					
DS_ID:19780					
EP_NO: N/A					
Repair Type: No Action Needed					
Crossing Status: Found					
UCIP Comments:					
FIELD_STRUCT_DESC: 36-inch C.M. stormdrain pipe through the					
levee, 9.8-feet below the crown. Flap gate on the waterward end.					
Concrete headwall on the landward end. Concrete "U" headwall on the					
waterward end. (USACE-1967). This entry matches the Drainage or					
Irrigation Structure referenced in O&M manual (HLM 19.92).					
FS Date: 4/23/2014

Headwall, pipe, and flapgate visible on WS toe.

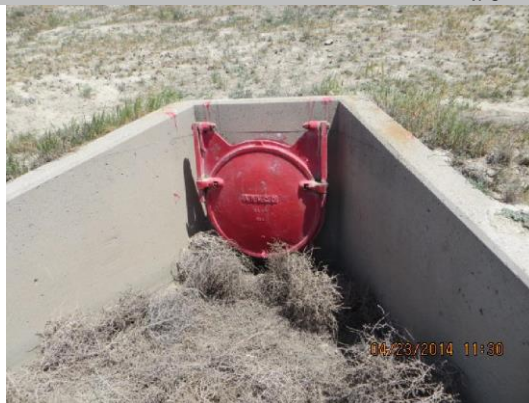
Photo 2 of 3 : UCIP\_SP\_2017\_34755\_62530.jpg

LM Start	19.94	Rating **	A/W	Issue No.	1358 (cont)	
LM End	19.94	Issue Type +	Ma	Location *	CR	
Category	Supplemental			GPS Latitude/Longitude		
				Start		End
Item	DWR UCIP LMA Responsibility			37.108426 °	37.108426 °	
				-120.554990 °	-120.554990 °	
DWR ID						
Comment Code						
Inspector Comment						
FS_ID:34755						
DS_ID:19780						
EP_NO: N/A						
Repair Type: No Action Needed						
Crossing Status: Found						
UCIP Comments:						
FIELD_STRUCT_DESC: 36-inch C.M. stormdrain pipe through the						
levee, 9.8-feet below the crown. Flap gate on the waterward end.						
Concrete headwall on the landward end. Concrete "U" headwall on the						
waterward end. (USACE-1967). This entry matches the Drainage or						
Irrigation Structure referenced in O&M manual (HLM 19.92).						
FS Date: 4/23/2014

Headwall, pipe, and flapgate visible on WS toe.

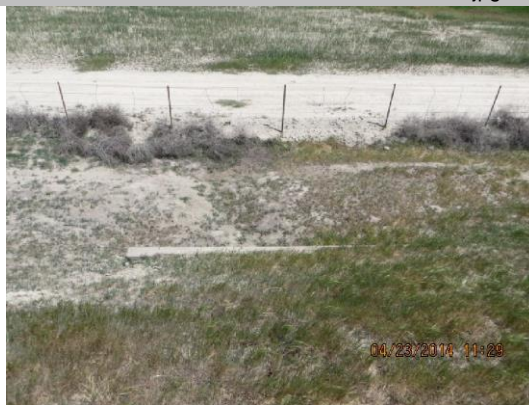
Photo 3 of 3 : UCIP\_SP\_2017\_34755\_62528.jpg

Headwall and pipe visible on LS toe.

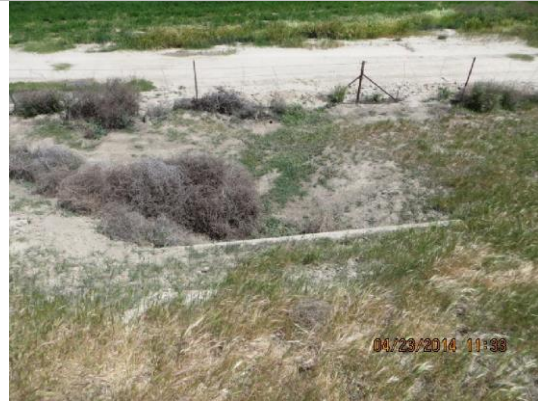
Photo 3 of 3 : UCIP\_SP\_2017\_34757\_62534.jpg

LM Start	20.10	Rating **	A/W	Issue No.	1359 (cont)	
LM End	20.10	Issue Type +	Ma	Location *	CR	
Category	Supplemental			GPS Latitude/Longitude		
				Start	End	
Item	DWR UCIP LMA Responsibility			37.107091 °	37.107091 °	
				-120.553503 °	-120.553503 °	
DWR ID						
Comment Code						
Inspector Comment						
FS_ID:34757						
DS_ID:19781						
EP_NO: N/A						
Repair Type: No Action Needed						
Crossing Status: Found						
UCIP Comments:						
FIELD_STRUCT_DESC: 36-inch C.M. stormdrain pipe through the						
levee, 9.9-feet below the crown. Flap gate on the waterward end.						
Concrete headwall on the landward end. Concrete "U" headwall on the						
waterward end. (USACE-1967). This entry matches the Drainage or						
Irrigation Structure referenced in O&M manual (HLM 20.05).						
FS Date: 4/23/2014

Headwall and pipe visible on LS toe.

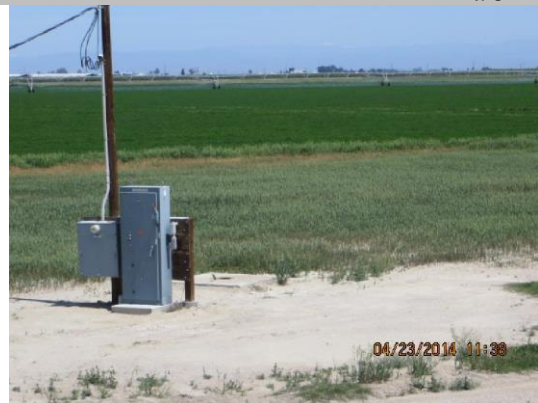
Photo 1 of 1 : UCIP\_SP\_2017\_34759\_62537.jpg

LM Start	20.19	Rating **	M	Issue No.	1360
LM End	20.19	Issue Type +	En	Location *	CR
Category	Supplemental			GPS Latitude/Longitude	
				Start	End
Item	DWR UCIP Field Study			37.106149 °	37.106149 °
				-120.552538 °	-120.552538 °
DWR ID					
Comment Code					
Inspector Comment					
FS_ID:34759 DS_ID:19782 EP_NO: 13828 Repair Type: Non-Urgent Crossing Status: Not Found UCIP Comments: FIELD_STRUCT_DESC: *DELETE* NOT INSTALLED THROUGH THE LEVEE. 24-inch steel irrigation pipe through the levee, 4.0 feet below the crown. Pump missing from pad on the landward side. Steel cutoff wall around pipe at center of levee. Siphon breaker on apex of pipe on landward shoulder. Pre-existing ditch runs from waterward toe to channel. Pipe extends from pump to the channel. Rock revetment on the cut slopes of the inlet channel. (Permit No. 13828-1988) FS Date: 4/23/2014

Well head visible off LS toe.

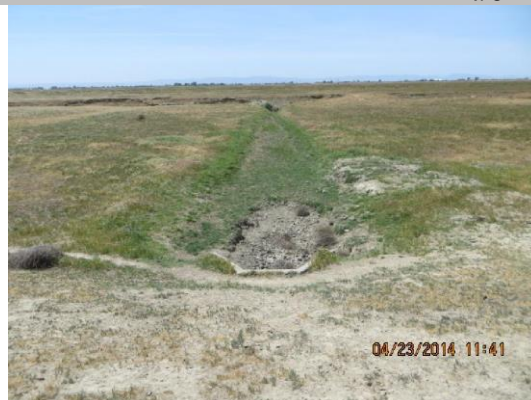
Photo 1 of 3 : UCIP\_SP\_2017\_34760\_62539.jpg

LM Start	20.24	Rating **	A/W	Issue No.	1361
LM End	20.24	Issue Type +	Ma	Location *	CR
Category	Supplemental			GPS Latitude/Longitude	
				Start	End
Item	DWR UCIP LMA Responsibility			37.105489 °	37.105489 °
				-120.551886 °	-120.551886 °
DWR ID					
Comment Code					
Inspector Comment					
FS_ID:34760 DS_ID:19783 EP_NO: N/A Repair Type: No Action Needed Crossing Status: Found UCIP Comments: FIELD_STRUCT_DESC: 36-inch C.M. stormdrain pipe through the levee, 10.6-feet below the crown. Flap gate on the waterward end. Concrete headwall on both sides (USACE-1967). This entry matches the Drainage or Irrigation Structure referenced in O&M manual (HLM 20.18). FS Date: 4/23/2014

Headwall, pipe, and flapgate visible on WS toe.

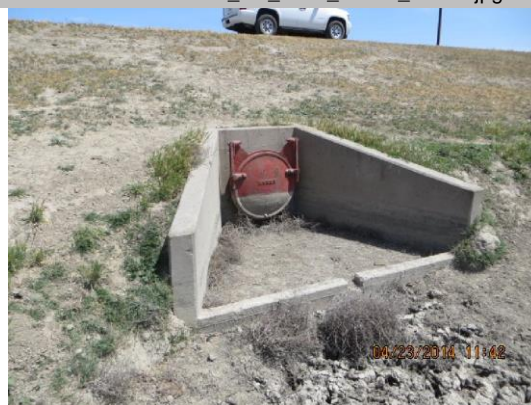
Photo 2 of 3 : UCIP\_SP\_2017\_34760\_62541.jpg

Headwall, pipe, and flapgate visible on WS toe.

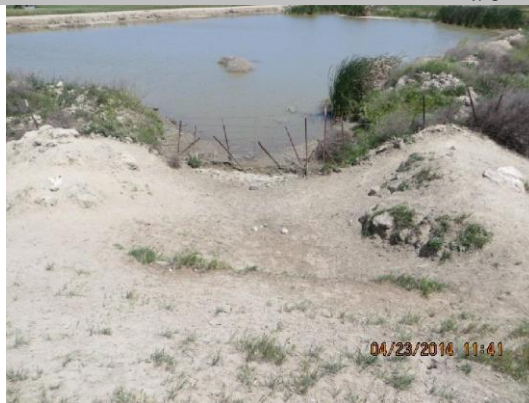
Photo 3 of 3 : UCIP\_SP\_2017\_34760\_62540.jpg

LM Start	20.24	Rating **	A/W	Issue No.	1361 (cont)
LM End	20.24	Issue Type +	Ma	Location *	CR
Category	Supplemental			GPS Latitude/Longitude	
				Start	End
Item	DWR UCIP LMA Responsibility			37.105489 °	37.105489 °
				-120.551886 °	-120.551886 °
DWR ID					
Comment Code					
Inspector Comment					
FS_ID:34760 DS_ID:19783 EP_NO: N/A Repair Type: No Action Needed Crossing Status: Found UCIP Comments: FIELD_STRUCT_DESC: 36-inch C.M. stormdrain pipe through the levee, 10.6-feet below the crown. Flap gate on the waterward end. Concrete headwall on both sides (USACE-1967). This entry matches the Drainage or Irrigation Structure referenced in O&M manual (HLM 20.18). FS Date: 4/23/2014

Headwall and pipe visible on LS toe.

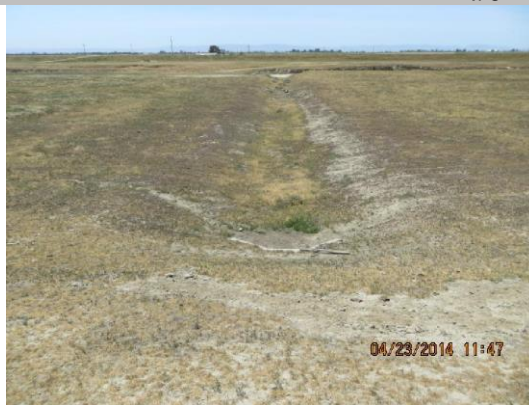
Photo 1 of 3 : UCIP\_SP\_2017\_39605\_62544.jpg

Comment Code					
Inspector Comment					
FS_ID:39605 DS_ID:19784 EP_NO: N/A Repair Type: Non-Urgent Crossing Status: Found UCIP Comments: Dense vegetation limits the inspector's visibility to identify signs of pipe failure (leaks) along the landward slope. Recommend removing vegetation along pipe alignment to conduct proper inspection of structure. FIELD_STRUCT_DESC: 24-inch C.M. pipe through the levee, 10.5 feet below the crown. Flap gate on the waterward end. Concrete headwall on the landward end. Concrete "U" headwall on the waterward end. (USACE-1967). This entry matches the Drainage or Irrigation Structure referenced in O&M manual (HLM 20.59). FS Date: 4/23/2014

Headwall, pipe, and flapgate visible on WS toe.

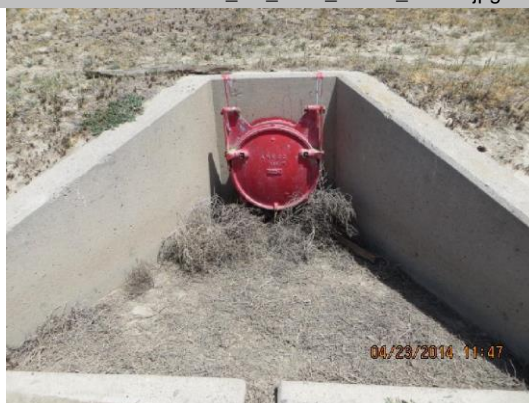
Photo 2 of 3 : UCIP\_SP\_2017\_39605\_62543.jpg

Item	DWR UCIP LMA Responsibility			37.100903 °		37.100903 °
				-120.547282 °		-120.547282 °
DWR ID						
Comment Code						
Inspector Comment						
FS_ID:39605						
DS_ID:19784						
EP_NO: N/A						
Repair Type: Non-Urgent						
Crossing Status: Found						
UCIP Comments: Dense vegetation limits the inspector's visibility to						
identify signs of pipe failure (leaks) along the landward slope.						
Recommend removing vegetation along pipe alignment to conduct						
proper inspection of structure.						
FIELD_STRUCT_DESC: 24-inch C.M. pipe through the levee, 10.5 feet						
below the crown. Flap gate on the waterward end. Concrete headwall						
on the landward end. Concrete "U" headwall on the waterward end.						
(USACE-1967). This entry matches the Drainage or Irrigation Structure						
referenced in O&M manual (HLM 20.59).						
FS Date: 4/23/2014

Headwall, pipe, and flapgate visible on WS toe.

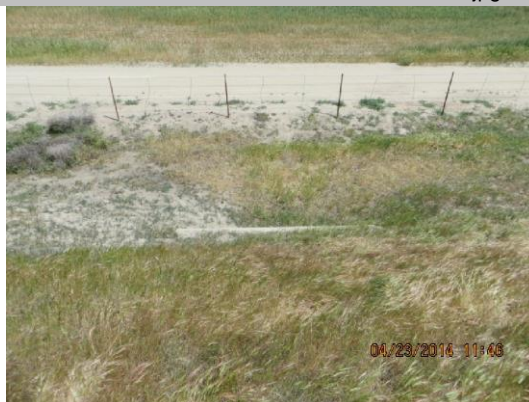
Photo 3 of 3 : UCIP\_SP\_2017\_39605\_62545.jpg

Headwall and pipe visible on LS toe.

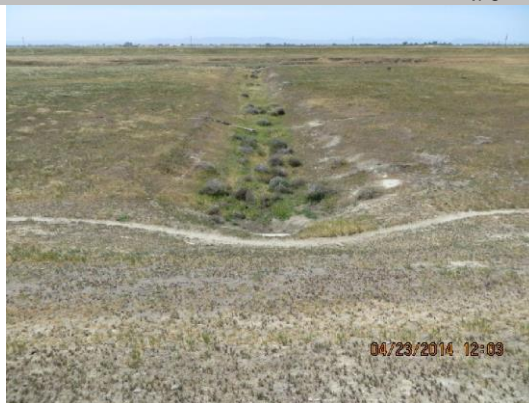
Photo 1 of 3 : UCIP\_SP\_2017\_39606\_62549.jpg

Comment Code					
Inspector Comment					
FS_ID:39606 DS_ID:19785 EP_NO: N/A Repair Type: Non-Urgent Crossing Status: Found UCIP Comments: Dense vegetation limits the inspector's visibility to identify signs of pipe failure (leaks) along the landward slope. Recommend removing vegetation along pipe alignment to conduct proper inspection of structure. FIELD_STRUCT_DESC: 24-inch C.M. stormdrain pipe through the levee, 11.8-feet below the crown. Flap gate on the waterward end. Concrete headwall on the landward end. Concrete "U" headwall on the waterward end. (USACE-1967). This entry matches the Drainage or Irrigation Structure referenced in O&M manual (HLM 21.08). FS Date: 4/23/2014

Headwall, pipe, and flapgate visible on WS toe.

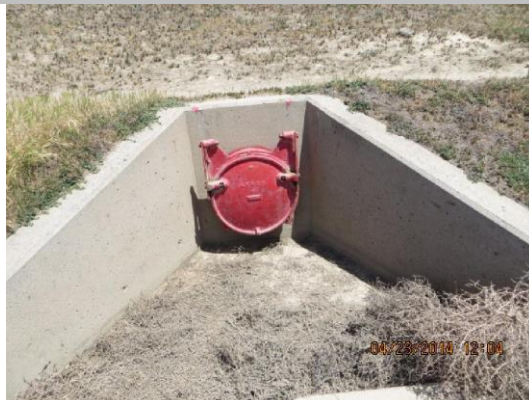
Photo 2 of 3 : UCIP\_SP\_2017\_39606\_62551.jpg

Headwall, pipe, and flapgate visible on WS toe.

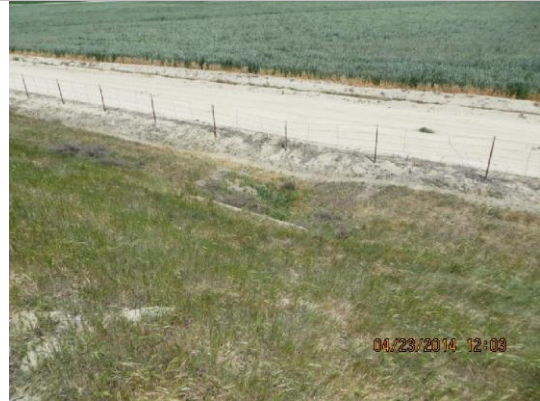
Photo 3 of 3 : UCIP\_SP\_2017\_39606\_62550.jpg

Item	DWR UCIP LMA Responsibility			37.095603 °	37.095603 °	
				-120.541593 °	-120.541593 °	
DWR ID						
Comment Code						
Inspector Comment						
FS_ID:39606 DS_ID:19785 EP_NO: N/A Repair Type: Non-Urgent Crossing Status: Found UCIP Comments: Dense vegetation limits the inspector's visibility to identify signs of pipe failure (leaks) along the landward slope. Recommend removing vegetation along pipe alignment to conduct proper inspection of structure. FIELD_STRUCT_DESC: 24-inch C.M. stormdrain pipe through the levee, 11.8-feet below the crown. Flap gate on the waterward end. Concrete headwall on the landward end. Concrete "U" headwall on the waterward end. (USACE-1967). This entry matches the Drainage or Irrigation Structure referenced in O&M manual (HLM 21.08). FS Date: 4/23/2014

Headwall and pipe visible on LS toe.

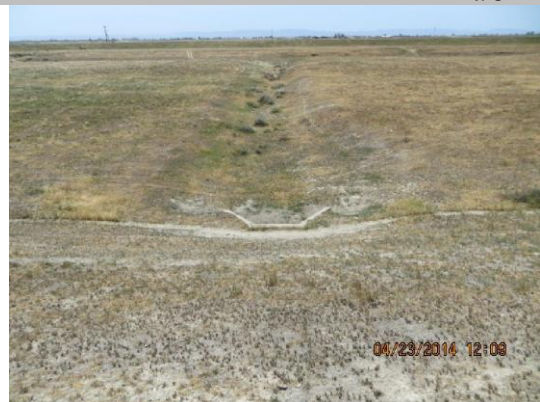
Photo 1 of 3 : UCIP\_SP\_2017\_39614\_62555.jpg

Comment Code					
Inspector Comment					
FS_ID:39614 DS_ID:19786 EP_NO: N/A Repair Type: Non-Urgent Crossing Status: Found UCIP Comments: Dense vegetation limits the inspector's visibility to identify signs of pipe failure (leaks) along the landward slope. Recommend removing vegetation along pipe alignment to conduct proper inspection of structure. FIELD_STRUCT_DESC: 36-inch C.M. stormdrain pipe through the levee, 12.7-feet below the crown. Flap gate on the waterward end. Concrete headwall on the landward end. Concrete "U" headwall on the waterward end. (USACE-1967). This entry matches the Drainage or Irrigation Structure referenced in O&M manual (HLM 21.42). FS Date: 4/23/2014

Headwall, pipe, and flapgate visible on WS toe.

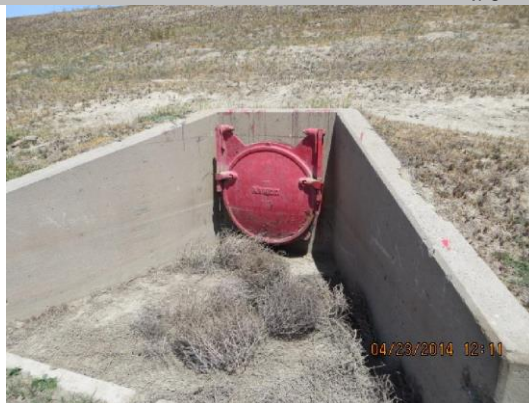
Photo 2 of 3 : UCIP\_SP\_2017\_39614\_62556.jpg

Item	DWR UCIP LMA Responsibility			37.091755 °		37.091755 °
				-120.537414 °		-120.537414 °
DWR ID						
Comment Code						
Inspector Comment						
FS_ID:39614 DS_ID:19786 EP_NO: N/A Repair Type: Non-Urgent Crossing Status: Found UCIP Comments: Dense vegetation limits the inspector's visibility to identify signs of pipe failure (leaks) along the landward slope. Recommend removing vegetation along pipe alignment to conduct proper inspection of structure. FIELD_STRUCT_DESC: 36-inch C.M. stormdrain pipe through the levee, 12.7-feet below the crown. Flap gate on the waterward end. Concrete headwall on the landward end. Concrete "U" headwall on the waterward end. (USACE-1967). This entry matches the Drainage or Irrigation Structure referenced in O&M manual (HLM 21.42). FS Date: 4/23/2014

Headwall, pipe, and flapgate visible on WS toe.

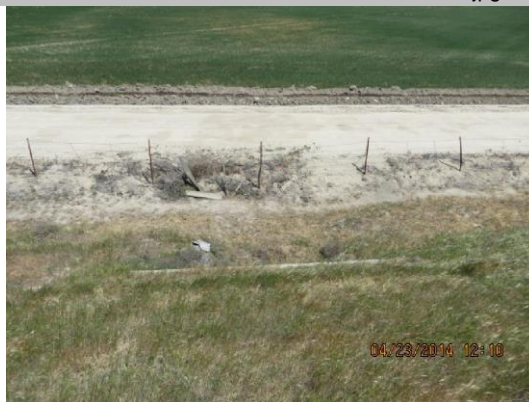
Photo 3 of 3 : UCIP\_SP\_2017\_39614\_62554.jpg

Headwall and pipe visible on LS toe.

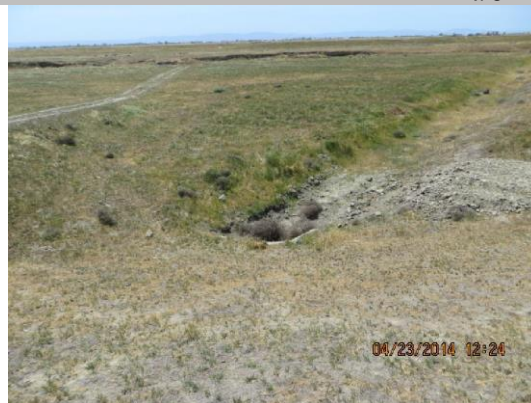
Photo 1 of 3 : UCIP\_SP\_2017\_39883\_62559.jpg

Comment Code					
Inspector Comment					
FS_ID:39883 DS_ID:19787 EP_NO: N/A Repair Type: Non-Urgent Crossing Status: Found UCIP Comments: Dense vegetation limits the inspector's visibility to identify signs of pipe failure (leaks) along the landward slope. Recommend removing vegetation along pipe alignment to conduct proper inspection of structure. FIELD_STRUCT_DESC: 24-inch C.M. stormdrain pipe through the levee, 12.4-feet below the crown. Flap gate on the waterward end. Concrete headwall on the landward end. Concrete "U" headwall on the waterward end. (USACE-1967). This entry matches the Drainage or Irrigation Structure referenced in O&M manual (HLM 21.81). FS Date: 4/23/2014

Headwall, pipe, and flapgate visible on WS toe.

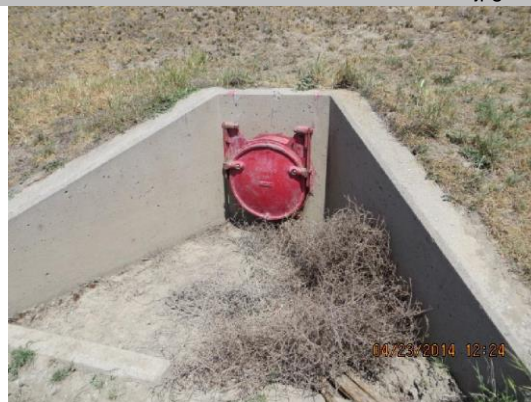
Photo 2 of 3 : UCIP\_SP\_2017\_39883\_62558.jpg

Headwall, pipe, and flapgate visible on WS toe.

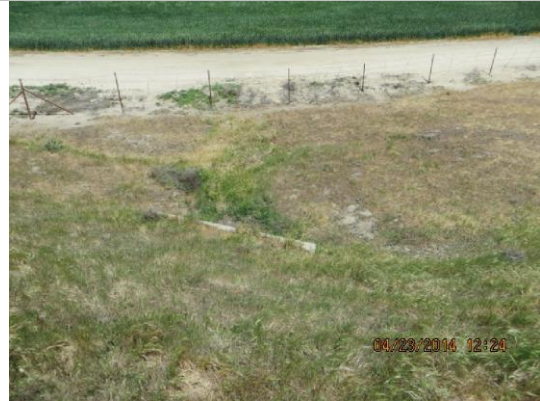
Photo 3 of 3 : UCIP\_SP\_2017\_39883\_62560.jpg

Item	DWR UCIP LMA Responsibility			37.087525 °		37.087525 °
				-120.532827 °		-120.532827 °
DWR ID						
Comment Code						
Inspector Comment						
FS_ID:39883 DS_ID:19787 EP_NO: N/A Repair Type: Non-Urgent Crossing Status: Found UCIP Comments: Dense vegetation limits the inspector's visibility to identify signs of pipe failure (leaks) along the landward slope. Recommend removing vegetation along pipe alignment to conduct proper inspection of structure. FIELD_STRUCT_DESC: 24-inch C.M. stormdrain pipe through the levee, 12.4-feet below the crown. Flap gate on the waterward end. Concrete headwall on the landward end. Concrete "U" headwall on the waterward end. (USACE-1967). This entry matches the Drainage or Irrigation Structure referenced in O&M manual (HLM 21.81). FS Date: 4/23/2014

Headwall and pipe visible on LS toe.

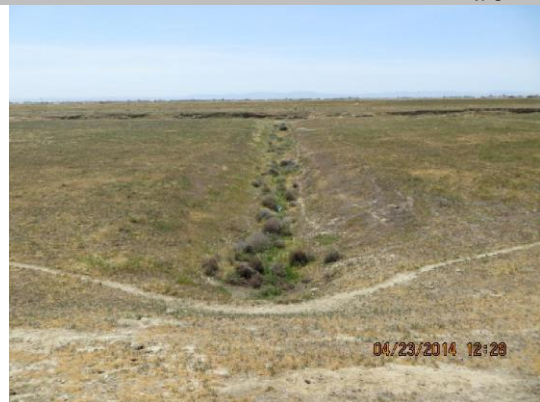
Photo 1 of 3 : UCIP\_SP\_2017\_39610\_62586.jpg

Comment Code					
Inspector Comment					
FS_ID:39610 DS_ID:19788 EP_NO: N/A Repair Type: Non-Urgent Crossing Status: Found UCIP Comments: Dense vegetation limits the inspector's visibility to identify signs of pipe failure (leaks) along the landward slope. Recommend removing vegetation along pipe alignment to conduct proper inspection of structure. FIELD_STRUCT_DESC: 24-inch C.M. stormdrain pipe through the levee, 10.7-feet below the crown. Flap gate on the waterward end. Concrete headwall on the landward end. Concrete "U" headwall on the waterward end. (USACE-1967). This entry matches the Drainage or Irrigation Structure referenced in O&M manual (HLM 21.85). FS Date: 4/23/2014

Headwall, pipe, and flapgate visible on WS toe.

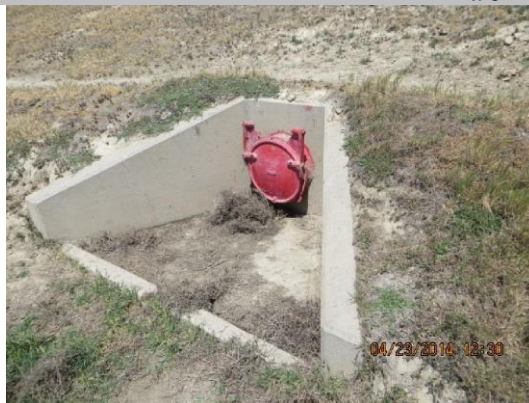
Photo 2 of 3 : UCIP\_SP\_2017\_39610\_62588.jpg

FS\_ID:39610  
DS\_ID:19788  
EP\_NO: N/A  
Repair Type: Non-Urgent  
Crossing Status: Found  
UCIP Comments: Dense vegetation limits the inspector's visibility to identify signs of pipe failure (leaks) along the landward slope. Recommend removing vegetation along pipe alignment to conduct proper inspection of structure.  
FIELD\_STRUCT\_DESC: 24-inch C.M. stormdrain pipe through the levee, 10.7-feet below the crown. Flap gate on the waterward end. Concrete headwall on the landward end. Concrete "U" headwall on the waterward end. (USACE-1967). This entry matches the Drainage or Irrigation Structure referenced in O&M manual (HLM 21.85).  
FS Date: 4/23/2014

Headwall, pipe, and flapgate visible on WS toe.

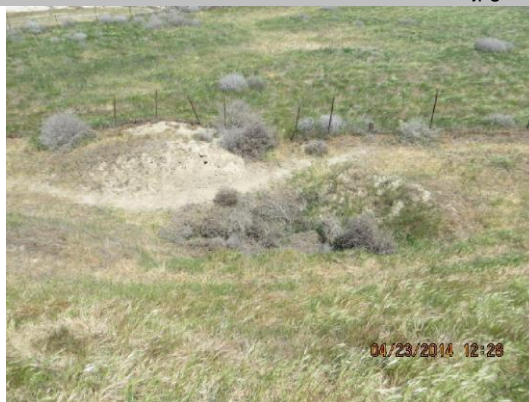
Photo 3 of 3 : UCIP\_SP\_2017\_39610\_62587.jpg

Headwall and pipe visible on LS toe.

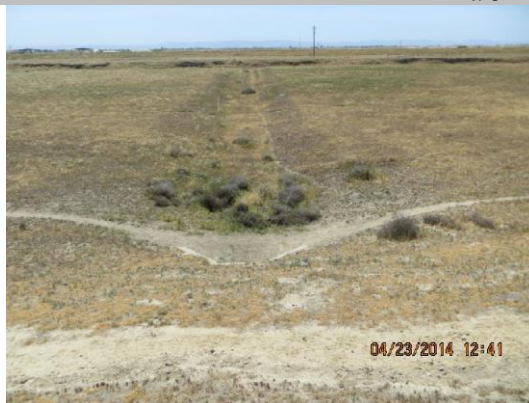
Photo 1 of 3 : UCIP\_SP\_2017\_39611\_62591.jpg

Comment Code					
Inspector Comment					
FS_ID:39611 DS_ID:19789 EP_NO: N/A Repair Type: Non-Urgent Crossing Status: Found UCIP Comments: Dense vegetation limits the inspector's visibility to identify signs of pipe failure (leaks) along the landward slope. Recommend removing vegetation along pipe alignment to conduct proper inspection of structure. Sediment buildup in pipe visible from landward side--recommend contacting owner to clear pipe. FIELD_STRUCT_DESC: 24-inch C.M. stormdrain pipe through the levee, 10.2-feet below the crown. Flap gate on the waterward end. Concrete headwall on the landward end. Concrete "U" headwall on the waterward end. (USACE-1967). This entry matches the Drainage or Irrigation Structure referenced in O&M manual (HLM 22.19). FS Date: 4/23/2014

Headwall, pipe, and flapgate visible on WS toe.

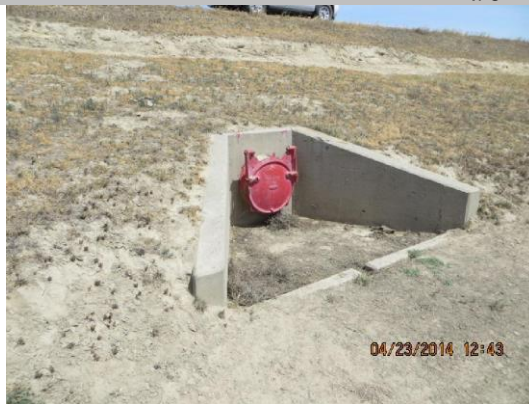
Photo 2 of 3 : UCIP\_SP\_2017\_39611\_62593.jpg

Headwall, pipe, and flapgate visible on WS toe.

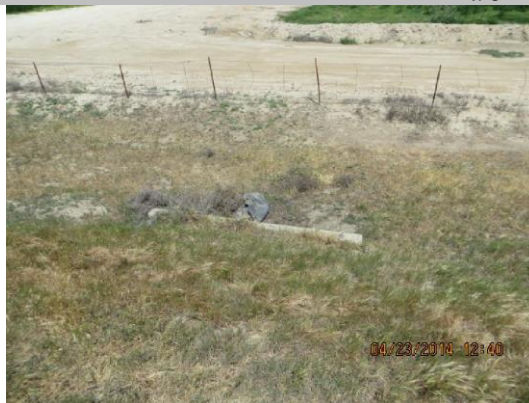
Photo 3 of 3 : UCIP\_SP\_2017\_39611\_62592.jpg

Item	DWR UCIP LMA Responsibility			37.083410 °	37.083410 °	
				-120.528356 °	-120.528356 °	
DWR ID						
Comment Code						
Inspector Comment						
FS_ID:39611 DS_ID:19789 EP_NO: N/A Repair Type: Non-Urgent Crossing Status: Found UCIP Comments: Dense vegetation limits the inspector's visibility to identify signs of pipe failure (leaks) along the landward slope. Recommend removing vegetation along pipe alignment to conduct proper inspection of structure. Sediment buildup in pipe visible from landward side--recommend contacting owner to clear pipe. FIELD_STRUCT_DESC: 24-inch C.M. stormdrain pipe through the levee, 10.2-feet below the crown. Flap gate on the waterward end. Concrete headwall on the landward end. Concrete "U" headwall on the waterward end. (USACE-1967). This entry matches the Drainage or Irrigation Structure referenced in O&M manual (HLM 22.19). FS Date: 4/23/2014

Headwall and pipe visible on LS toe.

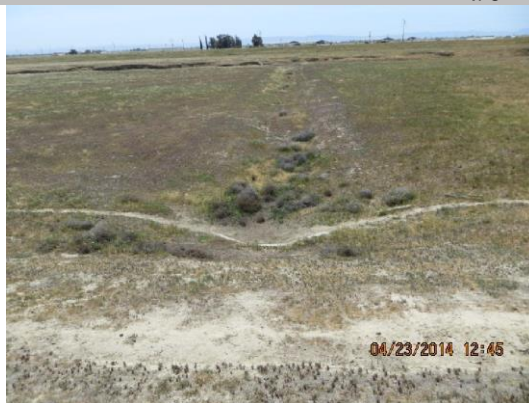
Photo 1 of 3 : UCIP\_SP\_2017\_39613\_62596.jpg

Comment Code					
Inspector Comment					
FS_ID:39613 DS_ID:19790 EP_NO: N/A Repair Type: Non-Urgent Crossing Status: Found UCIP Comments: Dense vegetation limits the inspector's visibility to identify signs of pipe failure (leaks) along the landward slope. Recommend removing vegetation along pipe alignment to conduct proper inspection of structure. Sediment buildup in pipe visible from landward side--recommend contacting owner to clear pipe. FIELD_STRUCT_DESC: 24-inch C.M. stormdrain pipe through the levee, 10.4-feet below the crown. Flap gate on the waterward end. Concrete headwall on the landward end. Concrete "U" headwall on the waterward end. (USACE-1967). This entry matches the Drainage or Irrigation Structure referenced in O&M manual (HLM 22.79). FS Date: 4/23/2014

Headwall, pipe, and flapgate visible on WS toe.

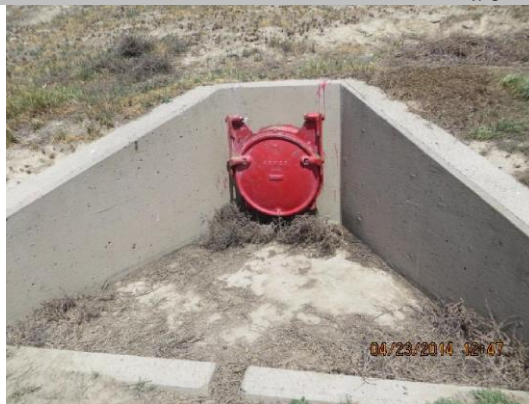
Photo 2 of 3 : UCIP\_SP\_2017\_39613\_62598.jpg

Headwall, pipe, and flapgate visible on WS toe.

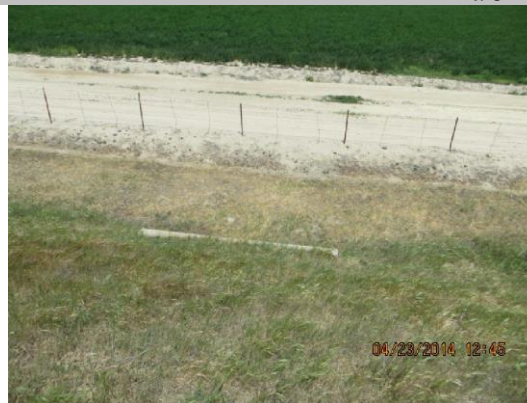
Photo 3 of 3 : UCIP\_SP\_2017\_39613\_62597.jpg

Item	DWR UCIP LMA Responsibility			37.080486 °	37.080486 °	
				-120.525180 °	-120.525180 °	
DWR ID						
Comment Code						
Inspector Comment						
FS_ID:39613 DS_ID:19790 EP_NO: N/A Repair Type: Non-Urgent Crossing Status: Found UCIP Comments: Dense vegetation limits the inspector's visibility to identify signs of pipe failure (leaks) along the landward slope. Recommend removing vegetation along pipe alignment to conduct proper inspection of structure. Sediment buildup in pipe visible from landward side--recommend contacting owner to clear pipe. FIELD_STRUCT_DESC: 24-inch C.M. stormdrain pipe through the levee, 10.4-feet below the crown. Flap gate on the waterward end. Concrete headwall on the landward end. Concrete "U" headwall on the waterward end. (USACE-1967). This entry matches the Drainage or Irrigation Structure referenced in O&M manual (HLM 22.79). FS Date: 4/23/2014

Headwall and pipe visible on LS toe.

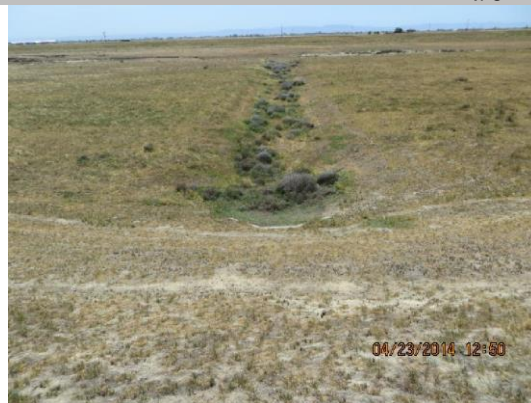
Photo 1 of 3 : UCIP\_SP\_2017\_39616\_62601.jpg

Comment Code					
Inspector Comment					
FS_ID:39616					
DS_ID:19791					
EP_NO: N/A					
Repair Type: Non-Urgent					
Crossing Status: Found					
UCIP Comments: Dense vegetation limits the inspector's visibility to identify signs of pipe failure (leaks) along the landward slope. Recommend removing vegetation along pipe alignment to conduct proper inspection of structure. Sediment buildup in pipe visible from landward side--recommend contacting owner to clear pipe.					
FIELD_STRUCT_DESC: 24-inch C.M. stormdrain pipe through the levee, 12.2-feet below the crown. Flap gate on the waterward end. Concrete headwall on the landward end. Concrete "U" headwall on the waterward end. (USACE-1967). This entry matches the Drainage or Irrigation Structure referenced in O&M manual (HLM 22.94).					
FS Date: 4/23/2014

Headwall, pipe, and flapgate visible on WS toe.

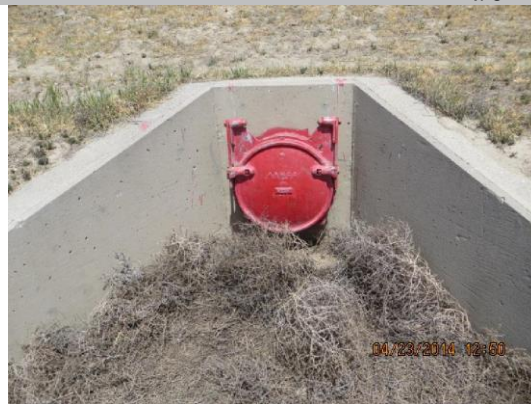
Photo 2 of 3 : UCIP\_SP\_2017\_39616\_62600.jpg

Headwall, pipe, and flapgate visible on WS toe.

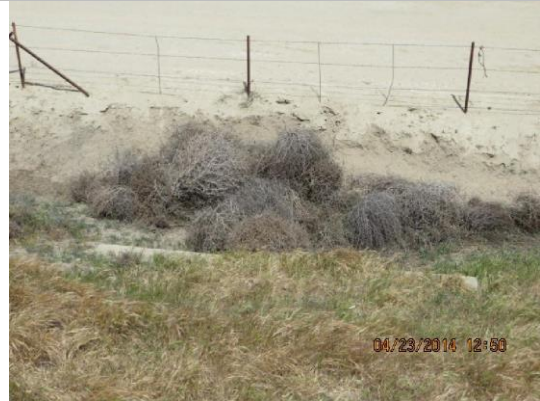
Photo 3 of 3 : UCIP\_SP\_2017\_39616\_62602.jpg

Item	DWR UCIP LMA Responsibility			37.076830 °		37.076830 °
				-120.521116 °		-120.521116 °
DWR ID						
Comment Code						
Inspector Comment						
FS_ID:39616						
DS_ID:19791						
EP_NO: N/A						
Repair Type: Non-Urgent						
Crossing Status: Found						
UCIP Comments: Dense vegetation limits the inspector's visibility to identify signs of pipe failure (leaks) along the landward slope.						
Recommend removing vegetation along pipe alignment to conduct proper inspection of structure. Sediment buildup in pipe visible from landward side--recommend contacting owner to clear pipe.						
FIELD_STRUCT_DESC: 24-inch C.M. stormdrain pipe through the levee, 12.2-feet below the crown. Flap gate on the waterward end. Concrete headwall on the landward end. Concrete "U" headwall on the waterward end. (USACE-1967). This entry matches the Drainage or Irrigation Structure referenced in O&M manual (HLM 22.94).

Headwall and pipe visible on LS toe.

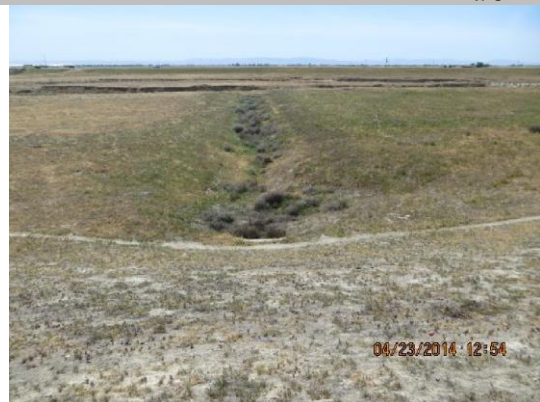
Photo 1 of 3 : UCIP\_SP\_2017\_39617\_62606.jpg

Comment Code					
Inspector Comment					
FS_ID:39617 DS_ID:19792 EP_NO: N/A Repair Type: Non-Urgent Crossing Status: Found UCIP Comments: Dense vegetation limits the inspector's visibility to identify signs of pipe failure (leaks) along the landward slope. Recommend removing vegetation along pipe alignment to conduct proper inspection of structure. FIELD_STRUCT_DESC: 24-inch C.M. stormdrain pipe through the levee, 11.1-feet below the crown. Flap gate on the waterward end. Concrete headwall on the landward end. Concrete "U" headwall on the waterward end. (USACE-1967). This entry matches the Drainage or Irrigation Structure referenced in O&M manual (HLM 22.79). FS Date: 4/23/2014

Headwall, pipe, and flapgate visible on WS toe.

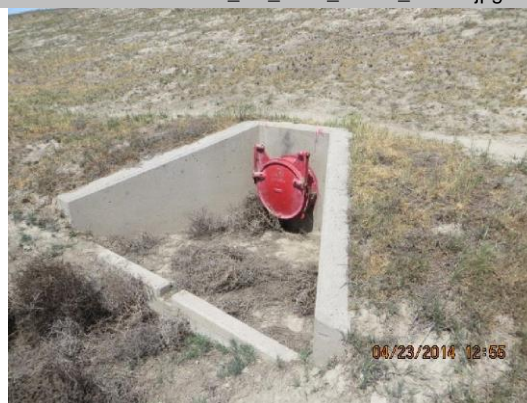
Photo 2 of 3 : UCIP\_SP\_2017\_39617\_62608.jpg

Item	DWR UCIP LMA Responsibility			37.075387 °	37.075387 °	
				-120.519406 °	-120.519406 °	
DWR ID						
Comment Code						
Inspector Comment						
FS_ID:39617 DS_ID:19792 EP_NO: N/A Repair Type: Non-Urgent Crossing Status: Found UCIP Comments: Dense vegetation limits the inspector's visibility to identify signs of pipe failure (leaks) along the landward slope. Recommend removing vegetation along pipe alignment to conduct proper inspection of structure. FIELD_STRUCT_DESC: 24-inch C.M. stormdrain pipe through the levee, 11.1-feet below the crown. Flap gate on the waterward end. Concrete headwall on the landward end. Concrete "U" headwall on the waterward end. (USACE-1967). This entry matches the Drainage or Irrigation Structure referenced in O&M manual (HLM 22.79). FS Date: 4/23/2014

Headwall, pipe, and flapgate visible on WS toe.

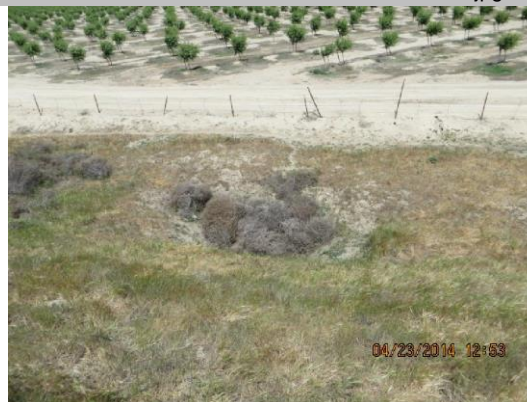
Photo 3 of 3 : UCIP\_SP\_2017\_39617\_62607.jpg

Headwall and pipe visible on LS toe.

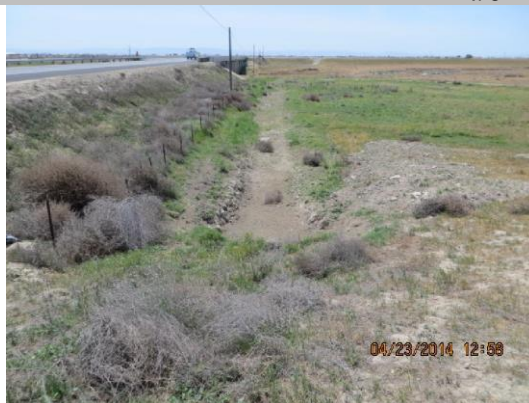
Photo 1 of 3 : UCIP\_SP\_2017\_39618\_62611.jpg

LM Start	23.17	Rating **	M	Issue No.	1371
LM End	23.17	Issue Type +	En	Location *	CR
Category	Supplemental			GPS Latitude/Longitude	
				Start	End
Item	DWR UCIP Field Study			37.073901 °	37.073901 °
				-120.517651 °	-120.517651 °
DWR ID					
Comment Code					
Inspector Comment					
FS_ID:39618 DS_ID:19793 EP_NO: N/A Repair Type: Non-Urgent Crossing Status: Found UCIP Comments: Debris blocking closure of outlet. Dense vegetation limits the inspector's visibility to identify signs of pipe failure (leaks) along the waterward and landward slopes. Recommend removing vegetation along pipe alignment to conduct proper inspection of structure. FIELD_STRUCT_DESC: 24-inch C.M. stormdrain pipe through the levee, 11.5-feet below the crown. Flap gate on the waterward end. Concrete headwall on the landward end. Concrete "U" headwall on the waterward end. FS Date: 4/23/2014

Headwall, pipe, and flapgate visible on WS toe.
