**Flood Control Project Maintenance  
Levee Inspections**  
**LMA District Cover Sheet**  
**Spring 2017 Levee Inspection Results**

**Lower San Joaquin Levee District**

Waterway			Bank	Unit Miles
Unit No. 01 San Joaquin River			Right	22.52
	Spring (March - May)	Summer (June - August)	(September - November) Fall	Winter (December - February)
Unit Maintenance Rating (Fall Only)				
Date of Inspection	4/17/2017 - 4/20/2017			
DWR Inspector	Richard Willoughby			
Accompanied By

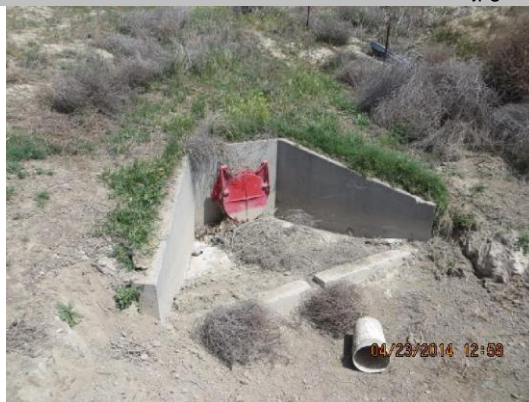
Photo 2 of 3 : UCIP\_SP\_2017\_39618\_62610.jpg

LM Start	23.17	Rating **	M	Issue No.	1371
LM End	23.17	Issue Type +	En	Location *	CR
Category	Supplemental			GPS Latitude/Longitude	
				Start	End
Item	DWR UCIP Field Study			37.073901 °	37.073901 °
				-120.517651 °	-120.517651 °
DWR ID					
Comment Code					
Inspector Comment					
FS_ID:39618 DS_ID:19793 EP_NO: N/A Repair Type: Non-Urgent Crossing Status: Found UCIP Comments: Debris blocking closure of outlet. Dense vegetation limits the inspector's visibility to identify signs of pipe failure (leaks) along the waterward and landward slopes. Recommend removing vegetation along pipe alignment to conduct proper inspection of structure. FIELD_STRUCT_DESC: 24-inch C.M. stormdrain pipe through the levee, 11.5-feet below the crown. Flap gate on the waterward end. Concrete headwall on the landward end. Concrete "U" headwall on the waterward end. FS Date: 4/23/2014

Headwall, pipe, and flapgate visible on WS toe.

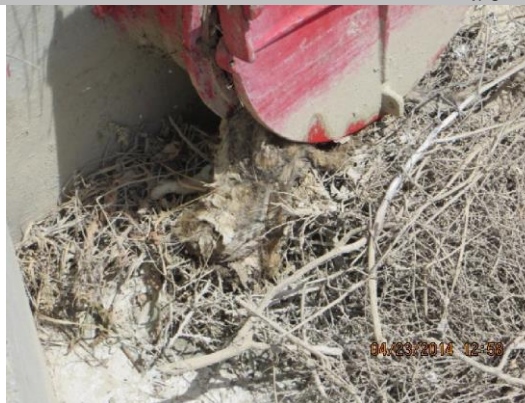
Photo 3 of 3 : UCIP\_SP\_2017\_39618\_62615.jpg

LM Start	23.17	Rating **	M	Issue No.	1371 (cont)	
LM End	23.17	Issue Type +	En	Location *	CR	
Category	Supplemental			GPS Latitude/Longitude		
				Start		End
Item	DWR UCIP Field Study			37.073901 °		37.073901 °
				-120.517651 °		-120.517651 °
DWR ID						
Comment Code						
Inspector Comment						
FS_ID:39618 DS_ID:19793 EP_NO: N/A Repair Type: Non-Urgent Crossing Status: Found UCIP Comments: Debris blocking closure of outlet. Dense vegetation limits the inspector's visibility to identify signs of pipe failure (leaks) along the waterward and landward slopes. Recommend removing vegetation along pipe alignment to conduct proper inspection of structure. FIELD_STRUCT_DESC: 24-inch C.M. stormdrain pipe through the levee, 11.5-feet below the crown. Flap gate on the waterward end. Concrete headwall on the landward end. Concrete "U" headwall on the waterward end. FS Date: 4/23/2014

Debris blocking closure of outlet on WS toe.

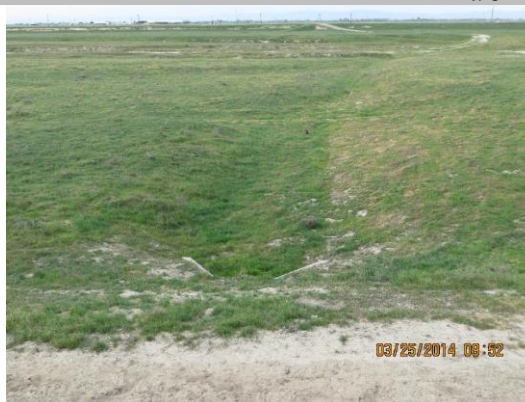
Photo 1 of 3 : UCIP\_SP\_2017\_32763\_59262.jpg

LM Start	23.25	Rating **	A/W	Issue No.	1372
LM End	23.25	Issue Type +	Ma	Location *	CR
Category	Supplemental			GPS Latitude/Longitude	
				Start	End
Item	DWR UCIP LMA Responsibility			37.072989 °	37.072989 °
				-120.516687 °	-120.516687 °
DWR ID					
Comment Code					
Inspector Comment					
FS_ID:32763					
DS_ID:19794					
EP_NO: N/A					
Repair Type: No Action Needed					
Crossing Status: Found					
UCIP Comments:					
FIELD_STRUCT_DESC: 30-inch C.M. stormdrain pipe through the					
levee, 11.6 feet below the crown. Flap gate on the waterward end.					
Concrete headwall on the landward end. Concrete "U" headwall on the					
waterward end. (USACE-1967). This entry matches the Drainage or					
Irrigation Structure referenced in O&M manual (HLM 23.15).					
FS Date: 3/25/2014 9:04:45 AM

Concrete headwall on WS toe.

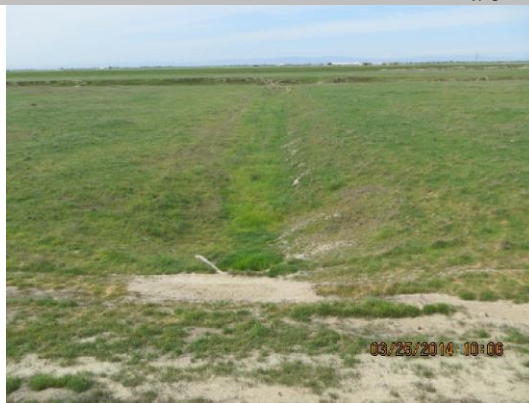
Photo 1 of 3 : UCIP\_SP\_2017\_39621\_59272.jpg

LM Start	23.72	Rating **	M	Issue No.	1373
LM End	23.72	Issue Type +	Ma	Location *	CR
Category	Supplemental			GPS Latitude/Longitude	
				Start	End
Item	DWR UCIP LMA Responsibility			37.067799 °	37.067799 °
				-120.511093 °	-120.511093 °
DWR ID					
Comment Code					
Inspector Comment					
FS_ID:39621 DS_ID:19796 EP_NO: N/A Repair Type: Non-Urgent Crossing Status: Found UCIP Comments: Sediment buildup in pipe visible from landward side--recommend contacting owner to clear pipe. FIELD_STRUCT_DESC: 30-inch C.M. pipe through the levee, 12.1 feet below the crown. Flap gate on the waterward end. Concrete "U" headwall on the waterward end. (USACE-1967). This entry matches the Drainage or Irrigation Structure referenced in O&M manual (HLM 23.62). FS Date: 3/25/2014

Concrete headwall on WS toe.

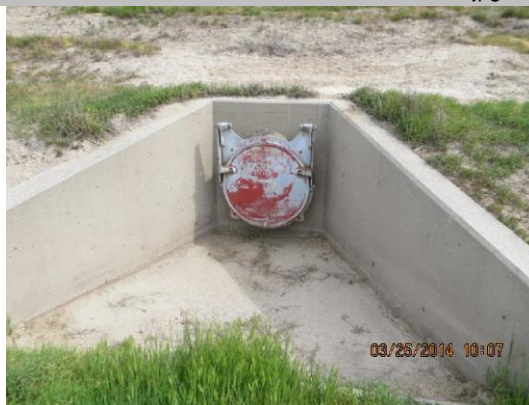
Photo 2 of 3 : UCIP\_SP\_2017\_39621\_59270.jpg

Flapgate on Concrete headwall on WS toe.

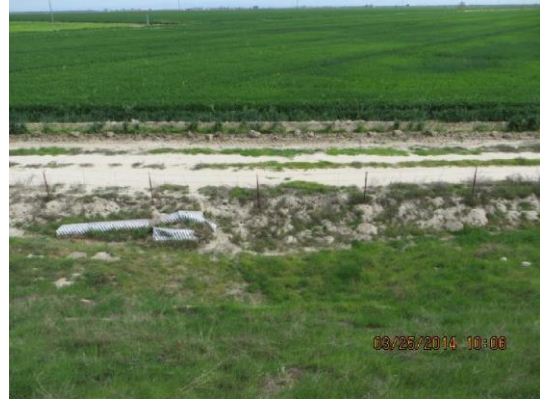
Photo 3 of 3 : UCIP\_SP\_2017\_39621\_59271.jpg

LM Start	23.72	Rating **	M	Issue No.	1373 (cont)
LM End	23.72	Issue Type +	Ma	Location *	CR
Category	Supplemental			GPS Latitude/Longitude	
				Start	End
Item	DWR UCIP LMA Responsibility			37.067799 °	37.067799 °
				-120.511093 °	-120.511093 °
DWR ID					
Comment Code					
Inspector Comment					
FS_ID:39621					
DS_ID:19796					
EP_NO: N/A					
Repair Type: Non-Urgent					
Crossing Status: Found					
UCIP Comments: Sediment buildup in pipe visible from landward side--recommend contacting owner to clear pipe.					
FIELD_STRUCT_DESC: 30-inch C.M. pipe through the levee, 12.1 feet below the crown. Flap gate on the waterward end. Concrete "U" headwall on the waterward end. (USACE-1967). This entry matches the Drainage or Irrigation Structure referenced in O&M manual (HLM 23.62).					
FS Date: 3/25/2014

Concrete headwall on LS toe.

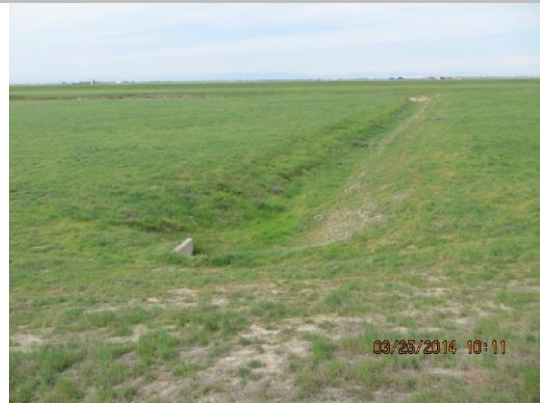
Photo 1 of 3 : UCIP\_SP\_2017\_39620\_59282.jpg

LM Start	24.02	Rating **	M	Issue No.	1374
LM End	24.02	Issue Type +	Ma	Location *	CR
Category	Supplemental			GPS Latitude/Longitude	
				Start	End
Item	DWR UCIP LMA Responsibility			37.064494 °	37.064494 °
				-120.507531 °	-120.507531 °
DWR ID					
Comment Code					
Inspector Comment					
FS_ID:39620 DS_ID:19797 EP_NO: N/A Repair Type: Non-Urgent Crossing Status: Found UCIP Comments: Minor sediment/debris buildup in pipe visible from landward side--recommend contacting owner to clear pipe. FIELD_STRUCT_DESC: 36-inch C.M. stormdrain pipe through the levee, 12.1 feet below the crown. Flap gate on the waterward end. Concrete headwall on the landward end. Concrete "U" headwall on the waterward end. (USACE-1967). This entry matches the Drainage or Irrigation Structure referenced in O&M manual (HLM 23.85). FS Date: 3/25/2014

Concrete headwall on WS toe.

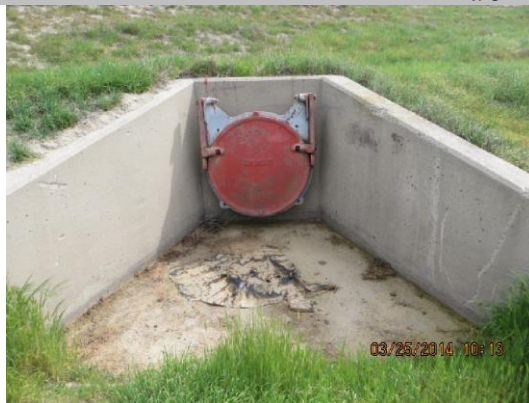
Photo 2 of 3 : UCIP\_SP\_2017\_39620\_59280.jpg

LM Start	24.02	Rating **	M	Issue No.	1374 (cont)	
LM End	24.02	Issue Type +	Ma	Location *	CR	
Category	Supplemental			GPS Latitude/Longitude		
				Start		End
Item	DWR UCIP LMA Responsibility			37.064494 °		37.064494 °
				-120.507531 °		-120.507531 °
DWR ID						
Comment Code						
Inspector Comment						
FS_ID:39620 DS_ID:19797 EP_NO: N/A Repair Type: Non-Urgent Crossing Status: Found UCIP Comments: Minor sediment/debris buildup in pipe visible from landward side--recommend contacting owner to clear pipe. FIELD_STRUCT_DESC: 36-inch C.M. stormdrain pipe through the levee, 12.1 feet below the crown. Flap gate on the waterward end. Concrete headwall on the landward end. Concrete "U" headwall on the waterward end. (USACE-1967). This entry matches the Drainage or Irrigation Structure referenced in O&M manual (HLM 23.85). FS Date: 3/25/2014

Flapgate at Concrete headwall on WS toe.

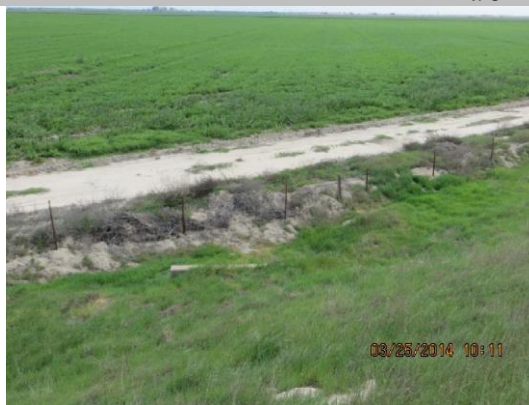
Photo 3 of 3 : UCIP\_SP\_2017\_39620\_59281.jpg

Concrete headwall on LS toe.

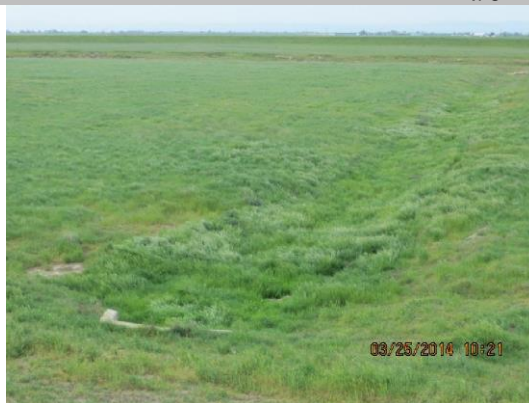
Photo 1 of 3 : UCIP\_SP\_2017\_46850\_59287.jpg

Comment Code					
Inspector Comment					
FS_ID:46850 DS_ID:19798 EP_NO: N/A Repair Type: Non-Urgent Crossing Status: Found UCIP Comments: Dense vegetation limits the inspector's visibility to identify signs of pipe failure (leaks) along the landward slope. Recommend removing vegetation along pipe alignment to conduct proper inspection of structure. FIELD_STRUCT_DESC: 24-inch C.M. stormdrain pipe through the levee, 11.2 feet below the crown. Flap gate on the waterward end. Concrete headwall on the landward end. Concrete "U" headwall on the waterward end. (USACE-1967). This entry matches the Drainage or Irrigation Structure referenced in O&M manual (HLM 24.18). FS Date: 3/25/2014

Concrete headwall at WS toe.

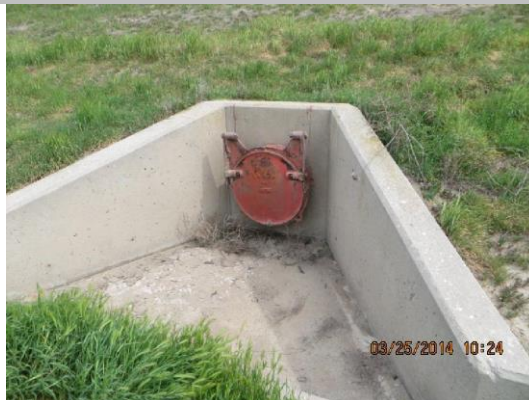
Photo 2 of 3 : UCIP\_SP\_2017\_46850\_59285.jpg

Flapgate at concrete headwall at WS toe.

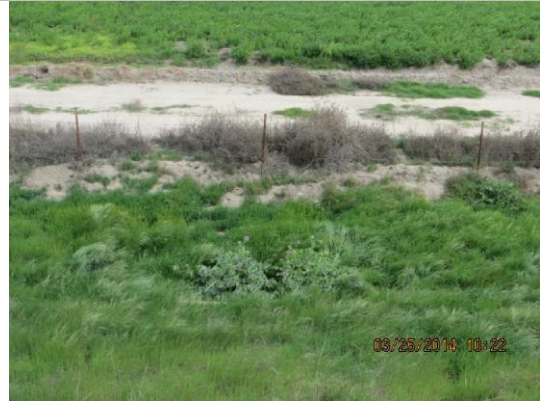
Photo 3 of 3 : UCIP\_SP\_2017\_46850\_59286.jpg

Item	DWR UCIP LMA Responsibility			37.061724 °	37.061724 °	
				-120.504512 °	-120.504512 °	
DWR ID						
Comment Code						
Inspector Comment						
FS_ID:46850 DS_ID:19798 EP_NO: N/A Repair Type: Non-Urgent Crossing Status: Found UCIP Comments: Dense vegetation limits the inspector's visibility to identify signs of pipe failure (leaks) along the landward slope. Recommend removing vegetation along pipe alignment to conduct proper inspection of structure. FIELD_STRUCT_DESC: 24-inch C.M. stormdrain pipe through the levee, 11.2 feet below the crown. Flap gate on the waterward end. Concrete headwall on the landward end. Concrete "U" headwall on the waterward end. (USACE-1967). This entry matches the Drainage or Irrigation Structure referenced in O&M manual (HLM 24.18). FS Date: 3/25/2014

Concrete headwall at LS toe.

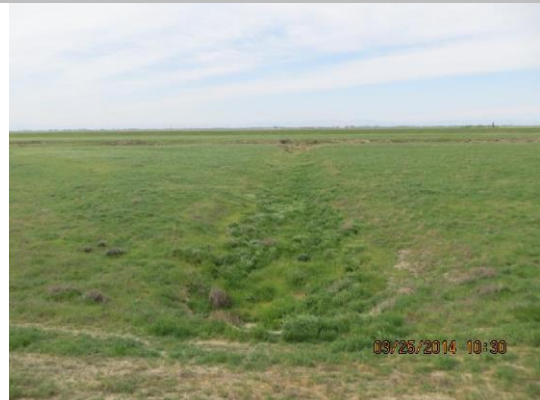
Photo 1 of 3 : UCIP\_SP\_2017\_39623\_59292.jpg

Comment Code					
Inspector Comment					
FS_ID:39623 DS_ID:19799 EP_NO: N/A Repair Type: Non-Urgent Crossing Status: Found UCIP Comments: Dense vegetation limits the inspector's visibility to identify signs of pipe failure (leaks) along the landward slope. Recommend removing vegetation along pipe alignment to conduct proper inspection of structure. FIELD_STRUCT_DESC: 24-inch C.M. stormdrain pipe through the levee, 11.2 feet below the crown. Flap gate on the waterward end. Concrete headwall on the landward end. Concrete "U" headwall on the waterward end. (USACE-1967). This entry matches the Drainage or Irrigation Structure referenced in O&M manual (HLM 24.46). FS Date: 3/25/2014

Concrete headwall on WS toe.

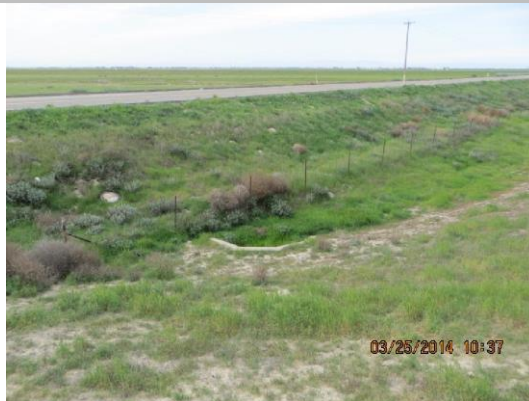
Photo 1 of 3 : UCIP\_SP\_2017\_32786\_59297.jpg

LM Start	24.93	Rating **	A/W	Issue No.	1377
LM End	24.93	Issue Type +	Ma	Location *	CR
Category	Supplemental			GPS Latitude/Longitude	
				Start	End
Item	DWR UCIP LMA Responsibility			37.054481 °	37.054481 °
				-120.496798 °	-120.496798 °
DWR ID					
Comment Code					
Inspector Comment					
FS_ID:32786					
DS_ID:19800					
EP_NO: N/A					
Repair Type: No Action Needed					
Crossing Status: Found					
UCIP Comments:					
FIELD_STRUCT_DESC: 24-inch C.M. pipe through the levee, 10.7 feet below the crown. Flap gate on the waterward end. Concrete headwall on the landward end. Concrete "U" headwall on the waterward end. (USACE-1967). This entry matches the Drainage or Irrigation Structure referenced in O&M manual (HLM 24.82).					
FS Date: 3/25/2014

Concrete headwall on WS toe.

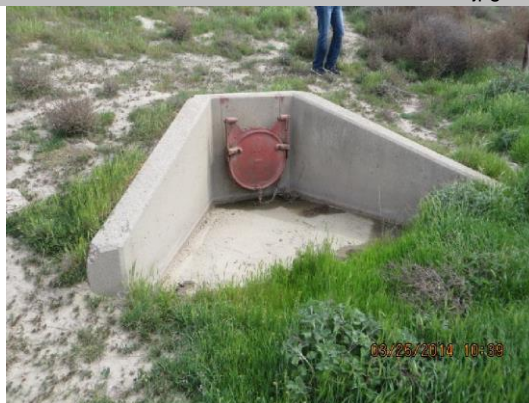
Photo 2 of 3 : UCIP\_SP\_2017\_32786\_59295.jpg

Flapgate on concrete headwall on WS toe.

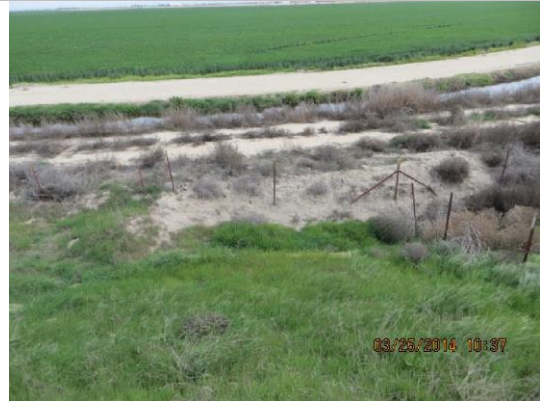
Photo 3 of 3 : UCIP\_SP\_2017\_32786\_59296.jpg

LM Start	24.93	Rating **	A/W	Issue No.	1377 (cont)	
LM End	24.93	Issue Type +	Ma	Location *	CR	
Category	Supplemental			GPS Latitude/Longitude		
				Start		End
Item	DWR UCIP LMA Responsibility			37.054481 °	37.054481 °	
				-120.496798 °	-120.496798 °	
DWR ID						
Comment Code						
Inspector Comment						
FS_ID:32786						
DS_ID:19800						
EP_NO: N/A						
Repair Type: No Action Needed						
Crossing Status: Found						
UCIP Comments:						
FIELD_STRUCT_DESC: 24-inch C.M. pipe through the levee, 10.7 feet below the crown. Flap gate on the waterward end. Concrete headwall on the landward end. Concrete "U" headwall on the waterward end. (USACE-1967). This entry matches the Drainage or Irrigation Structure referenced in O&M manual (HLM 24.82).						
FS Date: 3/25/2014

Concrete headwall on LS toe.

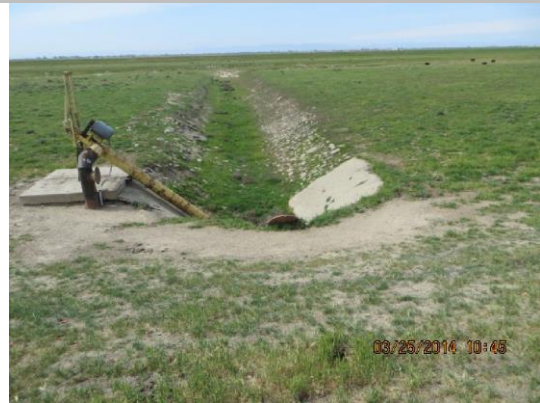
Photo 1 of 3 : UCIP\_SP\_2017\_39624\_59302.jpg

LM Start	24.96	Rating **	A/W	Issue No.	1378
LM End	24.96	Issue Type +	Ma	Location *	CR
Category	Supplemental			GPS Latitude/Longitude	
				Start	End
Item	DWR UCIP LMA Responsibility			37.054344 °	37.054344 °
				-120.496214 °	-120.496214 °
DWR ID					
Comment Code					
Inspector Comment					
FS_ID:39624					
DS_ID:19801					
EP_NO: N/A					
Repair Type: No Action Needed					
Crossing Status: Found					
UCIP Comments:					
FIELD_STRUCT_DESC: 30-inch C.M. pipe through the levee, 10.9 feet below the crown. Flap gate on the waterward end. Concrete headwall on the landward end. Concrete "U" headwall on the waterward end. (USACE-1967). This entry matches the Drainage or Irrigation Structure referenced in O&M manual (HLM 24.87).					
FS Date: 3/25/2014

Flapgate and channel off WS toe.

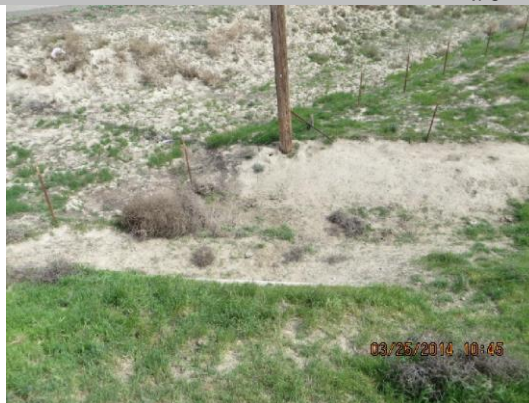
Photo 2 of 3 : UCIP\_SP\_2017\_39624\_59301.jpg

LM Start	24.96	Rating **	A/W	Issue No.	1378 (cont)
LM End	24.96	Issue Type +	Ma	Location *	CR
Category	Supplemental			GPS Latitude/Longitude	
				Start	End
Item	DWR UCIP LMA Responsibility			37.054344 °	37.054344 °
				-120.496214 °	-120.496214 °
DWR ID					
Comment Code					
Inspector Comment					
FS_ID:39624					
DS_ID:19801					
EP_NO: N/A					
Repair Type: No Action Needed					
Crossing Status: Found					
UCIP Comments:					
FIELD_STRUCT_DESC: 30-inch C.M. pipe through the levee, 10.9 feet below the crown. Flap gate on the waterward end. Concrete headwall on the landward end. Concrete "U" headwall on the waterward end. (USACE-1967). This entry matches the Drainage or Irrigation Structure referenced in O&M manual (HLM 24.87).					
FS Date: 3/25/2014

Concrete headwall on LS toe.

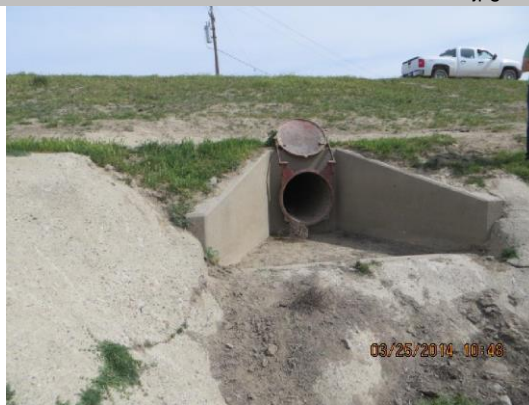
Photo 3 of 3 : UCIP\_SP\_2017\_39624\_59303.jpg

Flapgate on headwall at WS toe.

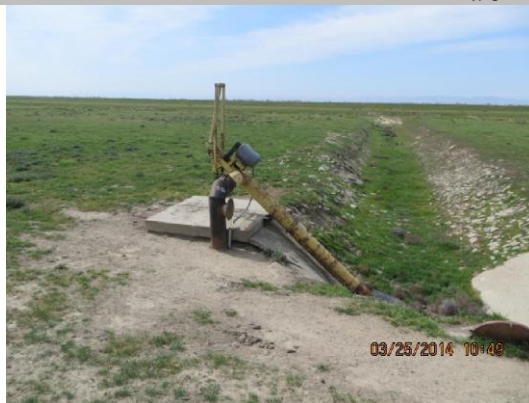
Photo 1 of 3 : UCIP\_SP\_2017\_41716\_59306.jpg

LM Start	24.98	Rating **	M	Issue No.	1379
LM End	24.98	Issue Type +	En	Location *	CR
Category	Supplemental			GPS Latitude/Longitude	
				Start	End
Item	DWR UCIP Field Study			37.054146 °	37.054146 °
				-120.495968 °	-120.495968 °
DWR ID					
Comment Code					
Inspector Comment					
FS_ID:41716 DS_ID:19802 EP_NO: 12873 Repair Type: Non-Urgent Crossing Status: Found UCIP Comments: Clear soil from siphon breaker and install a protective riser. FIELD_STRUCT_DESC: 16-inch steel irrigation pipe through the levee, 2.0 feet below the crown. Siphon breaker on waterward shoulder. Slant pump at channel on WS toe. Gatevalve on LS toe. Pre-existing ditch runs from waterward toe to channel. Riprap placed around intake. 2-inch PVC electrical conduit at same location (Permit No. 12873-1981) FS Date: 3/25/2014

Slant pump at channel on WS toe.

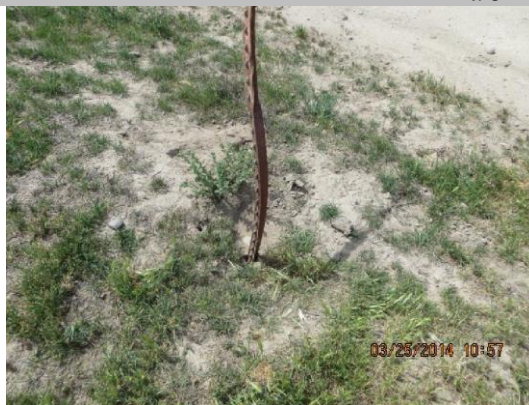
Photo 2 of 3 : UCIP\_SP\_2017\_41716\_59307.jpg

Buried Siphon breaker on WS shoulder.

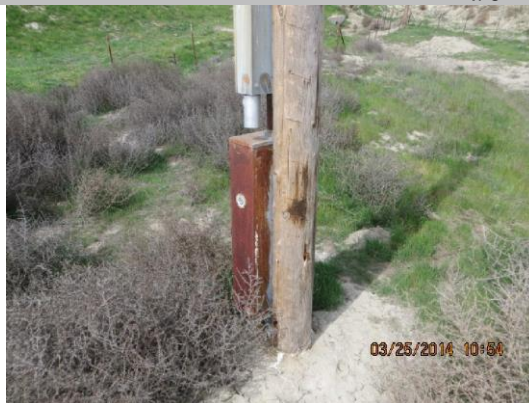
Photo 3 of 3 : UCIP\_SP\_2017\_41716\_59304.jpg

LM Start	24.98	Rating **	M	Issue No.	1379 (cont)
LM End	24.98	Issue Type +	En	Location *	CR
Category	Supplemental			GPS Latitude/Longitude	
				Start	End
Item	DWR UCIP Field Study			37.054146 °	37.054146 °
				-120.495968 °	-120.495968 °
DWR ID					
Comment Code					
Inspector Comment					
FS_ID:41716 DS_ID:19802 EP_NO: 12873 Repair Type: Non-Urgent Crossing Status: Found UCIP Comments: Clear soil from siphon breaker and install a protective riser. FIELD_STRUCT_DESC: 16-inch steel irrigation pipe through the levee, 2.0 feet below the crown. Siphon breaker on waterward shoulder. Slant pump at channel on WS toe. Gatevalve on LS toe. Pre-existing ditch runs from waterward toe to channel. Riprap placed around intake. 2-inch PVC electrical conduit at same location (Permit No. 12873-1981) FS Date: 3/25/2014

Power pole, meter, and electrical panel off LS toe.

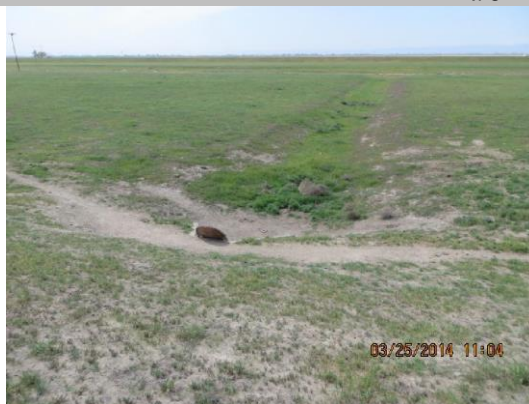
Photo 1 of 3 : UCIP\_SP\_2017\_32789\_59311.jpg

LM Start	25.24	Rating **	M	Issue No.	1380
LM End	25.24	Issue Type +	Ma	Location *	CR
Category	Supplemental			GPS Latitude/Longitude	
				Start	End
Item	DWR UCIP LMA Responsibility			37.051477 °	37.051477 °
				-120.492650 °	-120.492650 °
DWR ID					
Comment Code					
Inspector Comment					
FS_ID:32789					
DS_ID:19803					
EP_NO: N/A					
Repair Type: Non-Urgent					
Crossing Status: Found					
UCIP Comments: Flapgate propped open during flood season.					
FIELD_STRUCT_DESC: 30-inch C.M. stormdrain pipe through the					
levee, 11.3 feet below the crown. Flap gate on the waterward end.					
Concrete headwall on the landward end. Concrete "U" headwall on the					
waterward end. (USACE-1967). This entry matches the Drainage or					
Irrigation Structure referenced in O&M manual (HLM 25.13).					
FS Date: 3/25/2014

Concrete headwall and flapgate on WS toe.

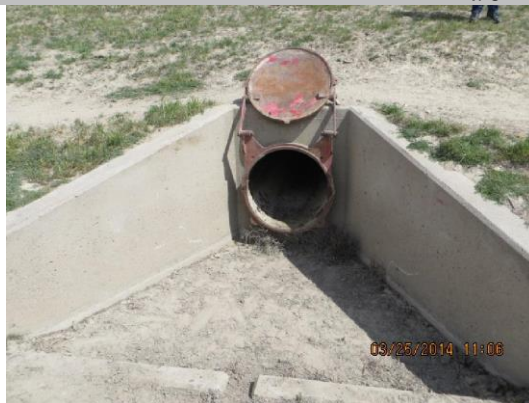
Photo 2 of 3 : UCIP\_SP\_2017\_32789\_59312.jpg

LM Start	25.24	Rating **	M	Issue No.	1380 (cont)	
LM End	25.24	Issue Type +	Ma	Location *	CR	
Category	Supplemental			GPS Latitude/Longitude		
				Start		End
Item	DWR UCIP LMA Responsibility			37.051477 °		37.051477 °
				-120.492650 °		-120.492650 °
DWR ID						
Comment Code						
Inspector Comment						
FS_ID:32789						
DS_ID:19803						
EP_NO: N/A						
Repair Type: Non-Urgent						
Crossing Status: Found						
UCIP Comments: Flapgate propped open during flood season.						
FIELD_STRUCT_DESC: 30-inch C.M. stormdrain pipe through the						
levee, 11.3 feet below the crown. Flap gate on the waterward end.						
Concrete headwall on the landward end. Concrete "U" headwall on the						
waterward end. (USACE-1967). This entry matches the Drainage or						
Irrigation Structure referenced in O&M manual (HLM 25.13).						
FS Date: 3/25/2014

Concrete headwall and flapgate on WS toe.

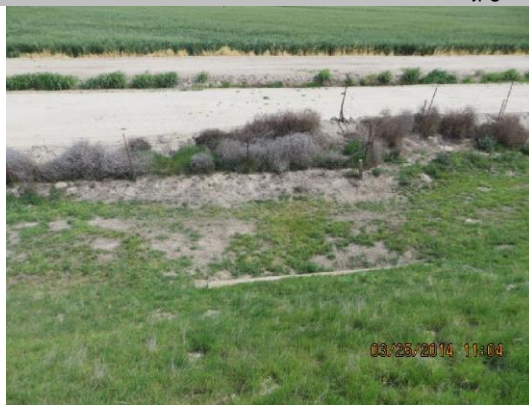
Photo 3 of 3 : UCIP\_SP\_2017\_32789\_59310.jpg

Concrete headwall on LS toe.

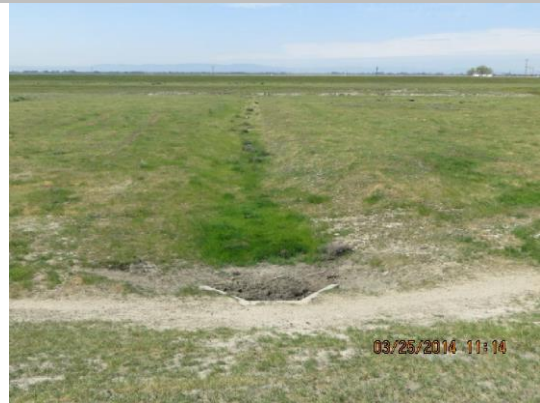
Photo 1 of 3 : UCIP\_SP\_2017\_39625\_59316.jpg

Comment Code					
Inspector Comment					
FS_ID:39625 DS_ID:19804 EP_NO: N/A Repair Type: Non-Urgent Crossing Status: Found UCIP Comments: Dense vegetation limits the inspector's visibility to identify signs of pipe failure (leaks) along the landward slope. Recommend removing vegetation along pipe alignment to conduct proper inspection of structure. Sediment buildup in pipe visible from landward side--recommend contacting owner to clear pipe. FIELD_STRUCT_DESC: 30-inch C.M. pipe through the levee, 12.0 feet below the crown. Flap gate on the waterward end. Concrete headwall on the landward end. Concrete "U" headwall on the waterward end. (USACE-1967). This entry matches the Drainage or Irrigation Structure referenced in O&M manual (HLM 25.51). FS Date: 3/25/2014

Concrete headwall on WS toe.

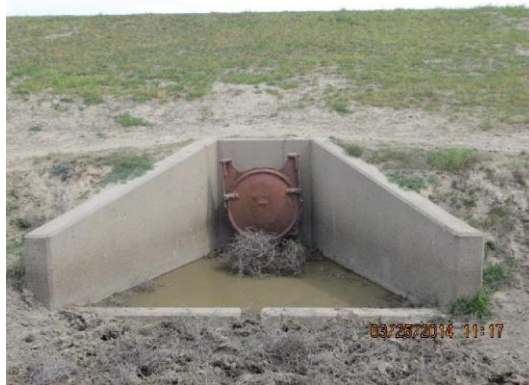
Photo 2 of 3 : UCIP\_SP\_2017\_39625\_59317.jpg

Comment Code					
Inspector Comment					
FS_ID:39625 DS_ID:19804 EP_NO: N/A Repair Type: Non-Urgent Crossing Status: Found UCIP Comments: Dense vegetation limits the inspector's visibility to identify signs of pipe failure (leaks) along the landward slope. Recommend removing vegetation along pipe alignment to conduct proper inspection of structure. Sediment buildup in pipe visible from landward side--recommend contacting owner to clear pipe. FIELD_STRUCT_DESC: 30-inch C.M. pipe through the levee, 12.0 feet below the crown. Flap gate on the waterward end. Concrete headwall on the landward end. Concrete "U" headwall on the waterward end. (USACE-1967). This entry matches the Drainage or Irrigation Structure referenced in O&M manual (HLM 25.51). FS Date: 3/25/2014

Flapgate on concrete headwall at WS toe.

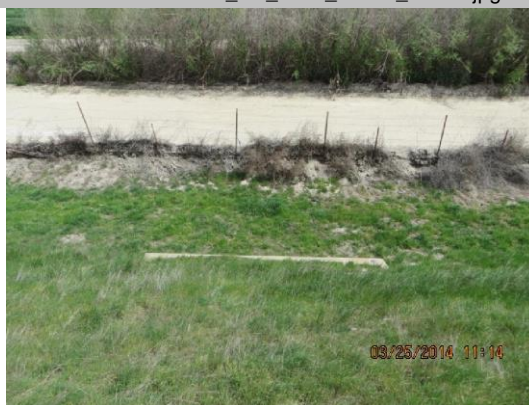
Photo 3 of 3 : UCIP\_SP\_2017\_39625\_59315.jpg

Concrete headwall on LS toe.

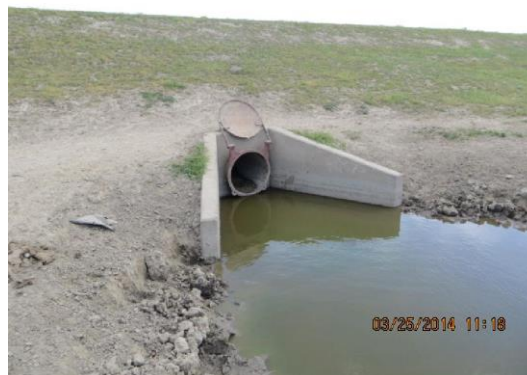
Photo 1 of 3 : UCIP\_SP\_2017\_39626\_59321.jpg

LM Start	25.63	Rating **	M	Issue No.	1382
LM End	25.63	Issue Type +	Ma	Location *	LS
Category	Supplemental			GPS Latitude/Longitude	
				Start	End
Item	DWR UCIP LMA Responsibility			37.047170 °	37.047170 °
				-120.488222 °	-120.488222 °
DWR ID					
Comment Code					
Inspector Comment					
FS_ID:39626					
DS_ID:19805					
EP_NO: N/A					
Repair Type: Non-Urgent					
Crossing Status: Found					
UCIP Comments: Sediment buildup in pipe visible from landward side-- recommend contacting owner to clear pipe.					
FIELD_STRUCT_DESC: 30-inch C.M. stormdrain pipe through the levee, 12.1 feet below the crown. Flap gate on the waterward end. Concrete headwall on the landward end. Concrete "U" headwall on the waterward end. (USACE-1967). This entry matches the Drainage or Irrigation Structure referenced in O&M manual (HLM 25.53).					
FS Date: 3/25/2014

Flapgate on headwall at WS toe.

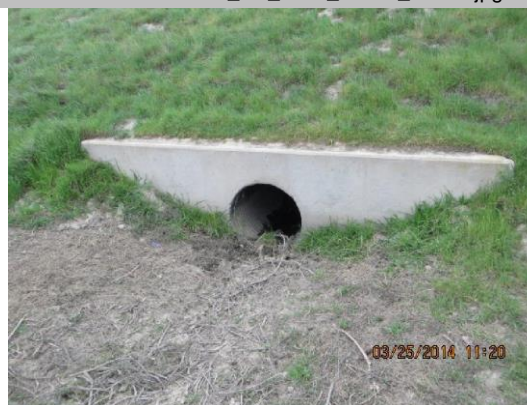
Photo 2 of 3 : UCIP\_SP\_2017\_39626\_59320.jpg

Concrete headwall on LS toe.

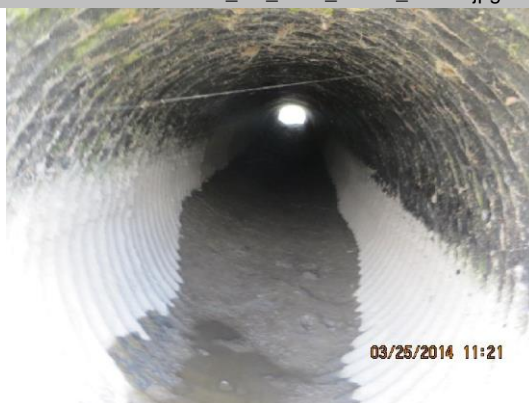
Photo 3 of 3 : UCIP\_SP\_2017\_39626\_59319.jpg

LM Start	25.63	Rating **	M	Issue No.	1382 (cont)
LM End	25.63	Issue Type +	Ma	Location *	LS
Category	Supplemental			GPS Latitude/Longitude	
				Start	End
Item	DWR UCIP LMA Responsibility			37.047170 °	37.047170 °
				-120.488222 °	-120.488222 °
DWR ID					
Comment Code					
Inspector Comment					
FS_ID:39626 DS_ID:19805 EP_NO: N/A Repair Type: Non-Urgent Crossing Status: Found UCIP Comments: Sediment buildup in pipe visible from landward side--recommend contacting owner to clear pipe. FIELD_STRUCT_DESC: 30-inch C.M. stormdrain pipe through the levee, 12.1 feet below the crown. Flap gate on the waterward end. Concrete headwall on the landward end. Concrete "U" headwall on the waterward end. (USACE-1967). This entry matches the Drainage or Irrigation Structure referenced in O&M manual (HLM 25.53). FS Date: 3/25/2014

Inside pipe on LS toe.

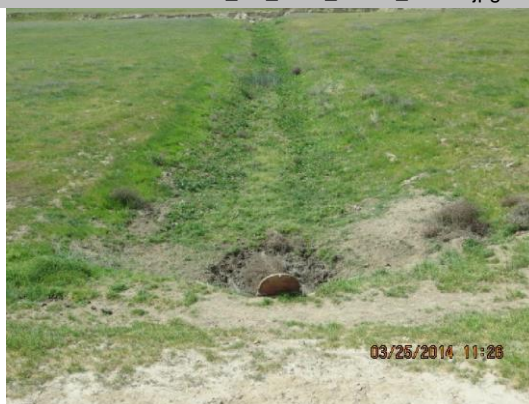
Photo 1 of 3 : UCIP\_SP\_2017\_39627\_59341.jpg

LM Start	26.20	Rating **	M	Issue No.	1383
LM End	26.20	Issue Type +	Ma	Location *	LS
Category	Supplemental			GPS Latitude/Longitude	
				Start	End
Item	DWR UCIP LMA Responsibility			37.040070 °	37.040070 °
				-120.482796 °	-120.482796 °
DWR ID					
Comment Code					
Inspector Comment					
FS_ID:39627					
DS_ID:19806					
EP_NO: N/A					
Repair Type: Non-Urgent					
Crossing Status: Found					
UCIP Comments: Sediment buildup in pipe visible from landward side--recommend contacting owner to clear pipe.					
FIELD_STRUCT_DESC: 24-inch C.M. stormdrain pipe through the levee, 10.0 feet below the crown. Flap gate on the waterward end. Concrete headwall on the landward end. Concrete "U" headwall on the waterward end. (USACE-1967). This entry matches the Drainage or Irrigation Structure referenced in O&M manual (HLM 26.11).					
FS Date: 3/25/2014

Concrete headwall on WS toe.

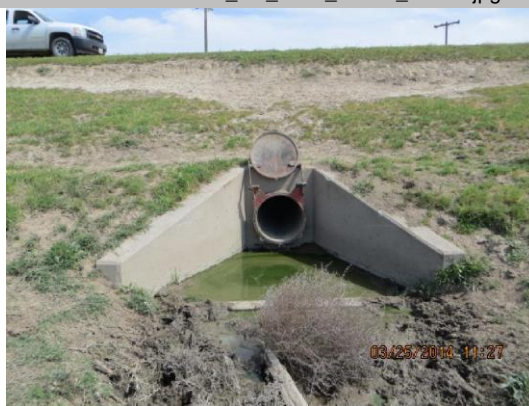
Photo 2 of 3 : UCIP\_SP\_2017\_39627\_59340.jpg

LM Start	26.20	Rating **	M	Issue No.	1383 (cont)
LM End	26.20	Issue Type +	Ma	Location *	LS
Category	Supplemental			GPS Latitude/Longitude	
				Start	End
Item	DWR UCIP LMA Responsibility			37.040070 °	37.040070 °
				-120.482796 °	-120.482796 °
DWR ID					
Comment Code					
Inspector Comment					
FS_ID:39627					
DS_ID:19806					
EP_NO: N/A					
Repair Type: Non-Urgent					
Crossing Status: Found					
UCIP Comments: Sediment buildup in pipe visible from landward side--recommend contacting owner to clear pipe.					
FIELD_STRUCT_DESC: 24-inch C.M. stormdrain pipe through the levee, 10.0 feet below the crown. Flap gate on the waterward end. Concrete headwall on the landward end. Concrete "U" headwall on the waterward end. (USACE-1967). This entry matches the Drainage or Irrigation Structure referenced in O&M manual (HLM 26.11).					
FS Date: 3/25/2014

Flapgate on Concrete headwall at WS toe.

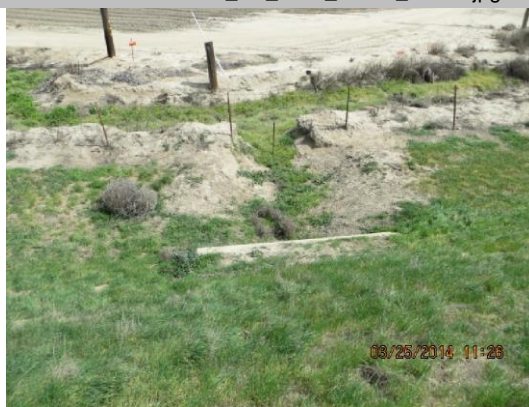
Photo 3 of 3 : UCIP\_SP\_2017\_39627\_59342.jpg

Concrete headwall on LS toe.

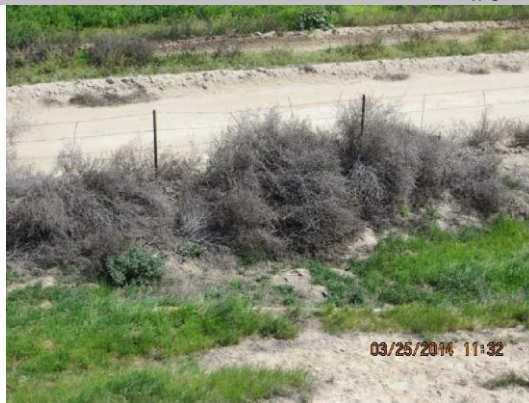
Photo 1 of 3 : UCIP\_SP\_2017\_32804\_59347.jpg

LM Start	26.39	Rating **	A/W	Issue No.	1384
LM End	26.39	Issue Type +	Ma	Location *	LS
Category	Supplemental			GPS Latitude/Longitude	
				Start	End
Item	DWR UCIP LMA Responsibility			37.037772 °	37.037772 °
				-120.481028 °	-120.481028 °
DWR ID					
Comment Code					
Inspector Comment					
FS_ID:32804					
DS_ID:19807					
EP_NO: N/A					
Repair Type: No Action Needed					
Crossing Status: Found					
UCIP Comments:					
FIELD_STRUCT_DESC: 36-inch C.M. stormdrain pipe through the					
levee, 13.0 feet below the crown. Flap gate on the waterward end.					
Concrete headwall on the landward end. Concrete "U" headwall on the					
waterward end. (USACE-1967). This entry matches the Drainage or					
Irrigation Structure referenced in O&M manual (HLM 26.29).					
FS Date: 3/25/2014

Concrete headwall on LS toe.

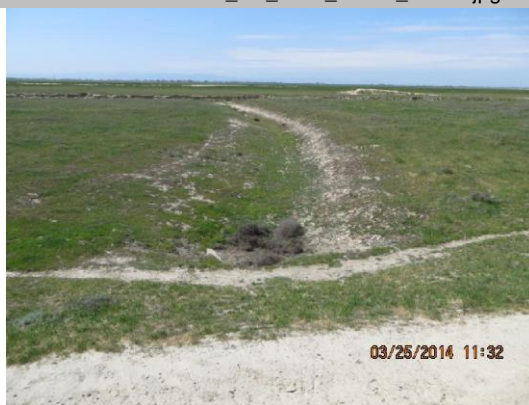
Photo 2 of 3 : UCIP\_SP\_2017\_32804\_59346.jpg

Concrete headwall on WS toe.

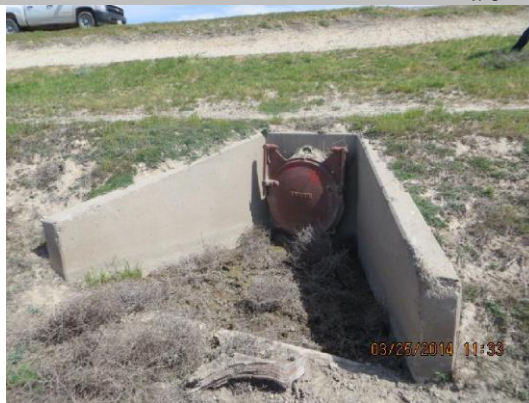
Photo 3 of 3 : UCIP\_SP\_2017\_32804\_59345.jpg

LM Start	26.39	Rating **	A/W	Issue No.	1384 (cont)	
LM End	26.39	Issue Type +	Ma	Location *	LS	
Category	Supplemental			GPS Latitude/Longitude		
				Start	End	
Item	DWR UCIP LMA Responsibility			37.037772 °	37.037772 °	
				-120.481028 °	-120.481028 °	
DWR ID						
Comment Code						
Inspector Comment						
FS_ID:32804						
DS_ID:19807						
EP_NO: N/A						
Repair Type: No Action Needed						
Crossing Status: Found						
UCIP Comments:						
FIELD_STRUCT_DESC: 36-inch C.M. stormdrain pipe through the						
levee, 13.0 feet below the crown. Flap gate on the waterward end.						
Concrete headwall on the landward end. Concrete "U" headwall on the						
waterward end. (USACE-1967). This entry matches the Drainage or						
Irrigation Structure referenced in O&M manual (HLM 26.29).						
FS Date: 3/25/2014

Flapgate on Concrete headwall at WS toe.

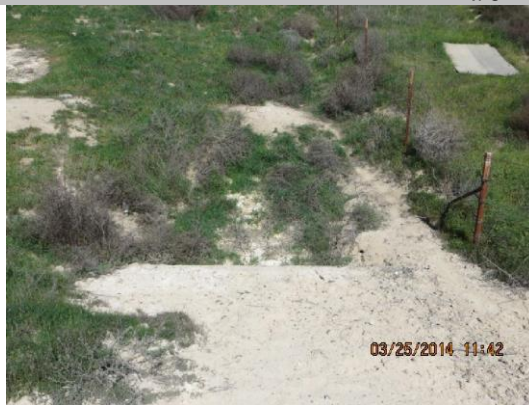
Photo 1 of 3 : UCIP\_SP\_2017\_39628\_59350.jpg

LM Start	26.95	Rating **	M	Issue No.	1385
LM End	26.95	Issue Type +	Ma	Location *	LS
Category	Supplemental			GPS Latitude/Longitude	
				Start	End
Item	DWR UCIP LMA Responsibility			37.032669 °	37.032669 °
				-120.473901 °	-120.473901 °
DWR ID					
Comment Code					
Inspector Comment					
FS_ID:39628 DS_ID:19808 EP_NO: N/A Repair Type: Non-Urgent Crossing Status: Found UCIP Comments: Pipe has heavy silt buildup visible from landward side--recommend contacting owner to clear pipe. FIELD_STRUCT_DESC: 24-inch C.M. stormdrain pipe through the levee, 11.4 feet below the crown. Flap gate on the waterward end. Concrete headwall on the landward end. Concrete "U" headwall on the waterward end. (USACE-1967). This entry matches the Drainage or Irrigation Structure referenced in O&M manual (HLM 26.85). FS Date: 3/25/2014

Concrete headwall on LS toe.

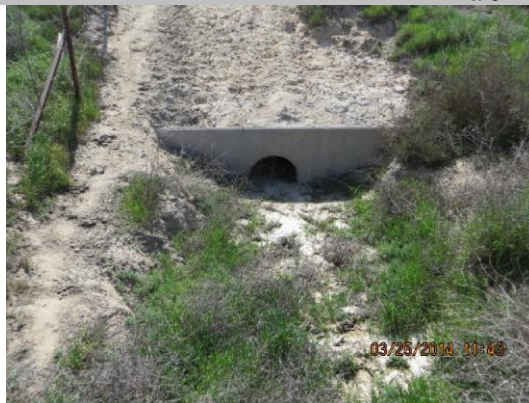
Photo 2 of 3 : UCIP\_SP\_2017\_39628\_59349.jpg

LM Start	26.95	Rating **	M	Issue No.	1385 (cont)
LM End	26.95	Issue Type +	Ma	Location *	LS
Category	Supplemental			GPS Latitude/Longitude	
				Start	End
Item	DWR UCIP LMA Responsibility			37.032669 °	37.032669 °
				-120.473901 °	-120.473901 °
DWR ID					
Comment Code					
Inspector Comment					
FS_ID:39628 DS_ID:19808 EP_NO: N/A Repair Type: Non-Urgent Crossing Status: Found UCIP Comments: Pipe has heavy silt buildup visible from landward side--recommend contacting owner to clear pipe. FIELD_STRUCT_DESC: 24-inch C.M. stormdrain pipe through the levee, 11.4 feet below the crown. Flap gate on the waterward end. Concrete headwall on the landward end. Concrete "U" headwall on the waterward end. (USACE-1967). This entry matches the Drainage or Irrigation Structure referenced in O&M manual (HLM 26.85). FS Date: 3/25/2014

Concrete headwall on LS toe.

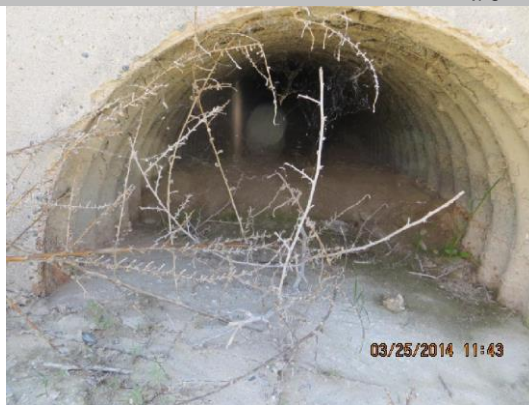
Photo 3 of 3 : UCIP\_SP\_2017\_39628\_59348.jpg

Silt buildup in pipe at LS toe.

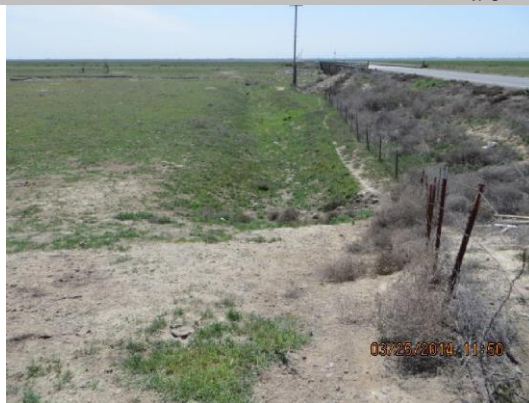
Photo 1 of 3 : UCIP\_SP\_2017\_32806\_59353.jpg

LM Start	26.97	Rating **	M	Issue No.	1386
LM End	26.97	Issue Type +	Ma	Location *	LS
Category	Supplemental			GPS Latitude/Longitude	
				Start	End
Item	DWR UCIP LMA Responsibility			37.032680 °	37.032680 °
				-120.473454 °	-120.473454 °
DWR ID					
Comment Code					
Inspector Comment					
FS_ID:32806 DS_ID:19748 EP_NO: N/A Repair Type: Non-Urgent Crossing Status: Found UCIP Comments: Tumble weed buildup at inlet mat create blockage and should be removed. FIELD_STRUCT_DESC: 24-inch C.M. stormdrain pipe through the levee, 11.3 feet below the crown. Flap gate on the waterward end. Concrete headwall on the landward end. Concrete "U" headwall on the waterward end. (USACE-1967). This entry matches the Drainage or Irrigation Structure referenced in O&M manual (HLM 26.87). FS Date: 3/25/2014

Concrete headwall at WS toe.

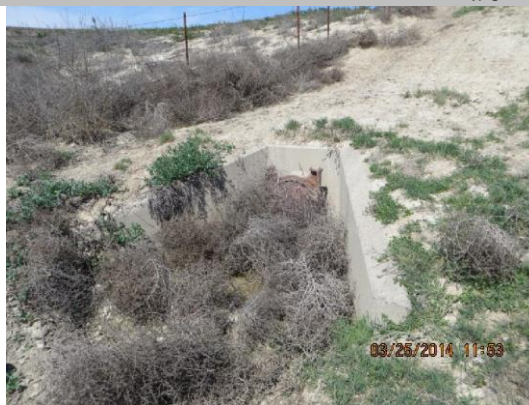
Photo 2 of 3 : UCIP\_SP\_2017\_32806\_59355.jpg

Flapgate and Concrete headwall at WS toe.

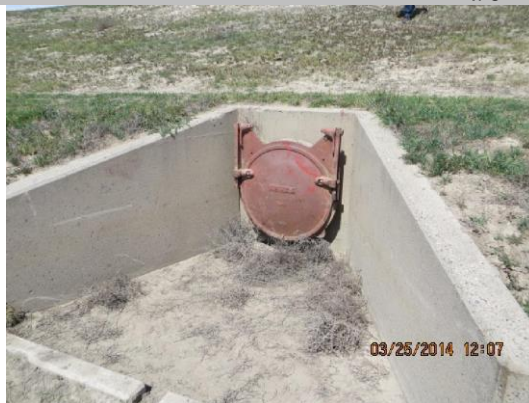
Photo 2 of 3 : UCIP\_SP\_2017\_32807\_59359.jpg

LM Start	27.31	Rating **	A/W	Issue No.	1387 (cont)
LM End	27.31	Issue Type +	Ma	Location *	LS
Category	Supplemental			GPS Latitude/Longitude	
				Start	End
Item	DWR UCIP LMA Responsibility			37.032668 °	37.032668 °
				-120.467299 °	-120.467299 °
DWR ID					
Comment Code					
Inspector Comment					
FS_ID:32807 DS_ID:19749 EP_NO: N/A Repair Type: No Action Needed Crossing Status: Found UCIP Comments: FIELD_STRUCT_DESC: 36-inch C.M. stormdrain pipe through the levee, 12.0 feet below the crown. Flap gate on the waterward end. Concrete headwall on the landward end. Concrete "U" headwall on the waterward end. (USACE-1967). This entry matches the Drainage or Irrigation Structure referenced in O&M manual (HLM 27.22). FS Date: 3/25/2014

Flapgate at Concrete headwall on WS toe.

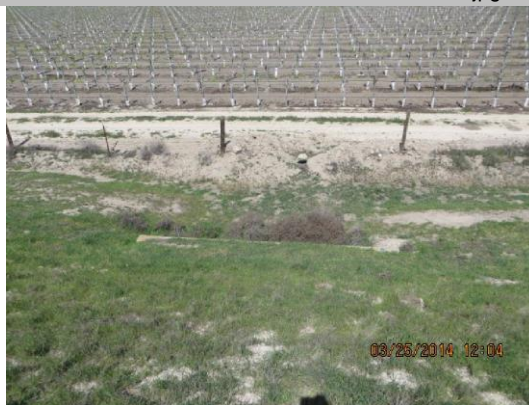
Photo 3 of 3 : UCIP\_SP\_2017\_32807\_59357.jpg

Concrete headwall on LS toe.

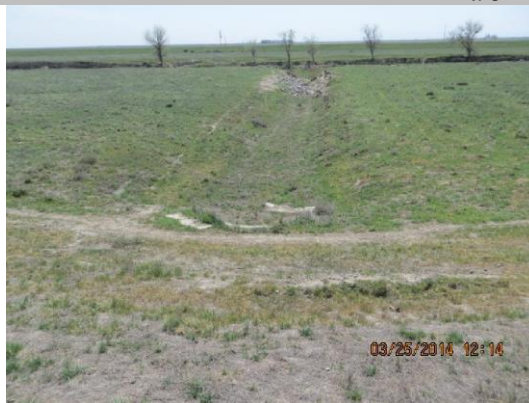
Photo 1 of 3 : UCIP\_SP\_2017\_32823\_59382.jpg

LM Start	28.27	Rating **	M	Issue No.	1388
LM End	28.27	Issue Type +	Ma	Location *	LS
Category	Supplemental			GPS Latitude/Longitude	
				Start	End
Item	DWR UCIP LMA Responsibility			37.032623 °	37.032623 °
				-120.450108 °	-120.450108 °
DWR ID					
Comment Code					
Inspector Comment					
FS_ID:32823 DS_ID:19750 EP_NO: N/A Repair Type: Non-Urgent Crossing Status: Found UCIP Comments: Animal Burrowing activity at LS toe may undermine headwall. FIELD_STRUCT_DESC: 24-inch C.M. stormdrain pipe through the levee, 10.8 feet below the crown. Flap gate on the waterward end. Concrete headwall on the landward end. Concrete "U" headwall on the waterward end. (USACE-1967). This entry matches the Drainage or Irrigation Structure referenced in O&M manual (HLM 28.17). FS Date: 3/25/2014

Concrete headwall on WS toe.

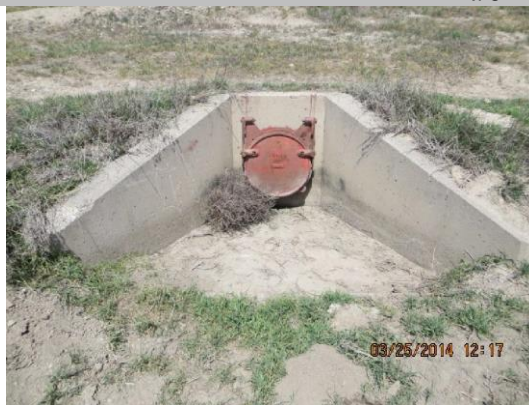
Photo 2 of 3 : UCIP\_SP\_2017\_32823\_59383.jpg

Flapgate on Concrete headwall at WS toe.

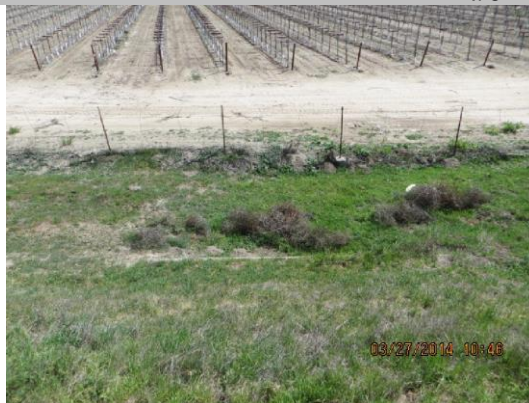
Photo 2 of 3 : UCIP\_SP\_2017\_32832\_59419.jpg

LM Start	28.79	Rating **	A/W	Issue No.	1389 (cont)
LM End	28.79	Issue Type +	Ma	Location *	LS
Category	Supplemental			GPS Latitude/Longitude	
				Start	End
Item	DWR UCIP LMA Responsibility			37.031640 °	37.031640 °
				-120.441389 °	-120.441389 °
DWR ID					
Comment Code					
Inspector Comment					
FS_ID:32832					
DS_ID:19751					
EP_NO: N/A					
Repair Type: No Action Needed					
Crossing Status: Found					
UCIP Comments:					
FIELD_STRUCT_DESC: 30-inch CM stormdrain pipe through levee, 9.8 feet below crown. Flap gate on waterward end. Concrete headwall on landward end. Concrete "U" headwall on the waterward end. (USACE-1967). This entry matches the Drainage or Irrigation Structure referenced in O&M manual (HLM 28.69).					
FS Date: 3/27/2014

Concrete headwall on LS toe.

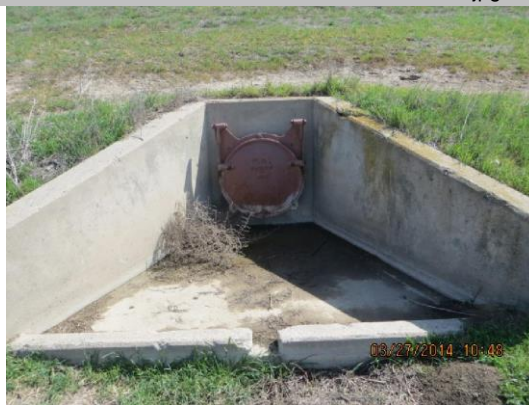
Photo 3 of 3 : UCIP\_SP\_2017\_32832\_59418.jpg

Flapgate on Concrete headwall at WS toe.

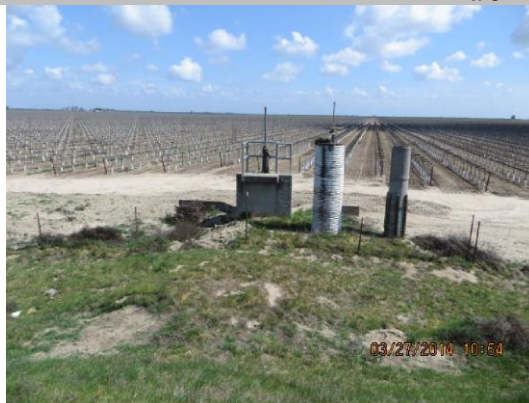
Photo 1 of 3 : UCIP\_SP\_2017\_50055\_59410.jpg

Comment Code					
Inspector Comment					
FS_ID:50055 DS_ID:19752 EP_NO: N/A Repair Type: Non-Urgent Crossing Status: Found UCIP Comments: 7/20/2016 same as previous inspection. Crossing has been downgraded from Urgent to Non-Urgent slide gate is on LS. Pipe is buried through WS. Need to coordinate with owner to determine permit used to authorized sleeved pipe. (DWR UCIP - omagana)3/27/2014 Slide gate will not close due to 24-inch PVC pipe sleeved through pipe. Also slide gate rails rusted beyond use. (DWR UCIP - omagana) FIELD_STRUCT_DESC: [Rodunder Siphon Structure] 48-inch concrete irrigation siphon pipe through the levee, 12.1 feet below the crown. Concrete "U" headwall on inlet structure located on the landside (LS) end. Slide gate mounted on concrete headwall located on the LS. 36-inch corrugated metal pipe (CMP) riser unit with slide gate, 8 feet upstream from siphon, located on the LS. 24-inch pipe from this unit enters siphon behind inlet structure. [Additional Reference(s): DWR Levee Log, 2002. USACE San Joaquin O&M Manuals: Unit No. 601, 1967, (HLM 28.95), Unit No. 601 Part I, 1967 (Amended in 1978), Unit No. 601 Part II, 1969, and Unit No. 601 Part III, 1969] FS Date: 7/20/2016

Slide gate mounted to concrete headwall on LS toe.

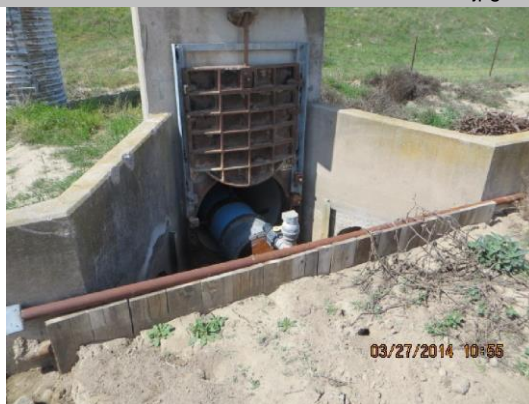
Photo 2 of 3 : UCIP\_SP\_2017\_50055\_59409.jpg

24-inch PVC pipe sleeved through 48-inch concrete pipe.

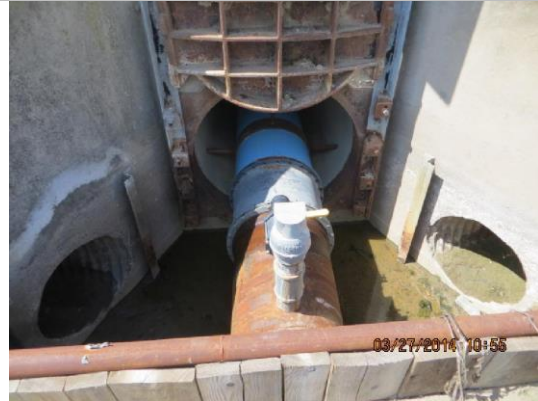
Photo 3 of 3 : UCIP\_SP\_2017\_50055\_59408.jpg

Item	DWR UCIP Field Study			37.028295 °	37.028295 °	
				-120.439275 °	-120.439275 °	
DWR ID						
Comment Code						
Inspector Comment						
FS_ID:50055						
DS_ID:19752						
EP_NO: N/A						
Repair Type: Non-Urgent						
Crossing Status: Found						
UCIP Comments: 7/20/2016 same as previous inspection. Crossing has been downgraded from Urgent to Non-Urgent slide gate is on LS. Pipe is buried through WS. Need to coordinate with owner to determine permit used to authorized sleeved pipe. (DWR UCIP - omagana)3/27/2014 Slide gate will not close due to 24-inch PVC pipe sleeved through pipe. Also slide gate rails rusted beyond use. (DWR UCIP - omagana)						
FIELD_STRUCT_DESC: [Rodunder Siphon Structure] 48-inch concrete irrigation siphon pipe through the levee, 12.1 feet below the crown. Concrete "U" headwall on inlet structure located on the landside (LS) end. Slide gate mounted on concrete headwall located on the LS. 36-inch corrugated metal pipe (CMP) riser unit with slide gate, 8 feet upstream from siphon, located on the LS. 24-inch pipe from this unit enters siphon behind inlet structure. [Additional Reference(s): DWR Levee Log, 2002. USACE San Joaquin O&M Manuals: Unit No. 601, 1967, (HLM 28.95), Unit No. 601 Part I, 1967 (Amended in 1978), Unit No. 601 Part II, 1969, and Unit No. 601 Part III, 1969]

24-inch PVC pipe sleeved through 48-inch concrete pipe. Rails on Slide gate rusted beyond use.

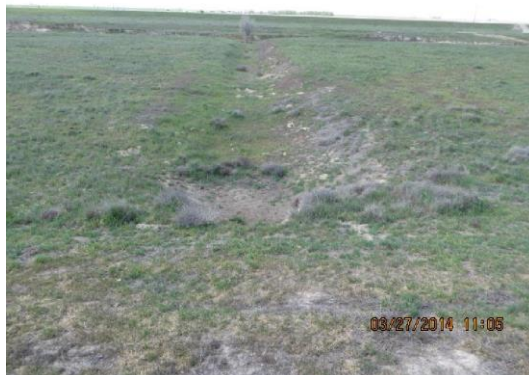
Photo 1 of 3 : UCIP\_SP\_2017\_39884\_59414.jpg

Comment Code					
Inspector Comment					
FS_ID:39884 DS_ID:19753 EP_NO: N/A Repair Type: Non-Urgent Crossing Status: Found UCIP Comments: Dense vegetation limits the inspector's visibility to identify signs of pipe failure (leaks) along the landward slope. Recommend removing vegetation along pipe alignment to conduct proper inspection of structure. Sediment buildup in pipe visible from landward side--recommend contacting owner to clear pipe. FIELD_STRUCT_DESC: 36-inch C.M. pipe through the levee, 10.2 feet below the crown. Flap gate on the waterward end. Concrete headwall on the landward end. Concrete "U" headwall on the waterward end. (USACE-1967). This entry matches the Drainage or Irrigation Structure referenced in O&M manual (HLM 29.49). FS Date: 3/27/2014

Concrete headwall on WS toe.

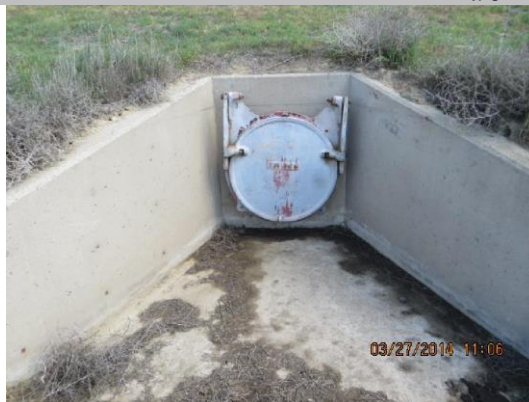
Photo 2 of 3 : UCIP\_SP\_2017\_39884\_59413.jpg

Flapgate on Concrete headwall at WS toe.

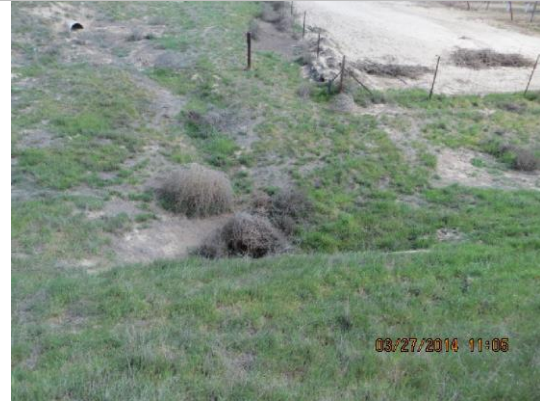
Photo 3 of 3 : UCIP\_SP\_2017\_39884\_59415.jpg

Comment Code					
Inspector Comment					
FS_ID:39884					
DS_ID:19753					
EP_NO: N/A					
Repair Type: Non-Urgent					
Crossing Status: Found					
UCIP Comments: Dense vegetation limits the inspector's visibility to identify signs of pipe failure (leaks) along the landward slope.					
Recommend removing vegetation along pipe alignment to conduct proper inspection of structure. Sediment buildup in pipe visible from landward side--recommend contacting owner to clear pipe.					
FIELD_STRUCT_DESC: 36-inch C.M. pipe through the levee, 10.2 feet below the crown. Flap gate on the waterward end. Concrete headwall on the landward end. Concrete "U" headwall on the waterward end. (USACE-1967). This entry matches the Drainage or Irrigation Structure referenced in O&M manual (HLM 29.49).					
FS Date: 3/27/2014

Concrete headwall on LS toe.

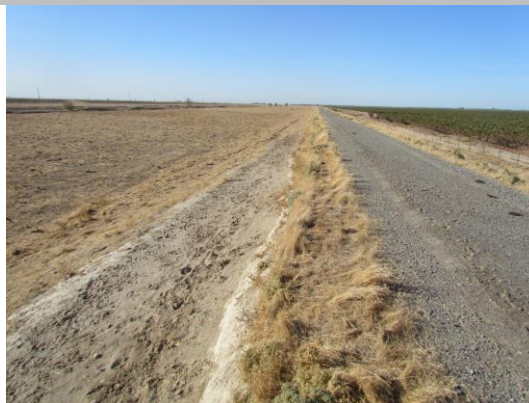
Photo 2 of 2 : SP\_2017\_NA0010\_123\_171\_20170417\_00012.jpg

LM Start	29.68	Rating **	M	Issue No.	171 (cont)	
LM End	29.80	Issue Type +	Ma	Location *	WS	
Category	Earthen Levee			GPS Latitude/Longitude		
				Start		End
Item	Erosion / Bank Caving			37.020272 °	37.018712 °	
				-120.433737 °	-120.432682 °	
DWR ID	DWR_NA0010_05_s_2014_171					
Comment Code						
E1 : Note and monitor erosion site.						
Inspector Comment						
Waterside erosion caused by livestock.

Looking north at animal erosion on waterward slope.

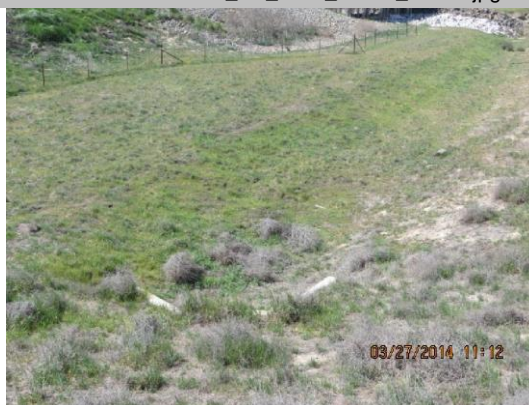
Photo 1 of 3 : UCIP\_SP\_2017\_39631\_59424.jpg

Comment Code					
Inspector Comment					
FS_ID:39631 DS_ID:19754 EP_NO: N/A Repair Type: Non-Urgent Crossing Status: Found UCIP Comments: Dense vegetation limits the inspector's visibility to identify signs of pipe failure (leaks) along the landward slope. Recommend removing vegetation along pipe alignment to conduct proper inspection of structure. FIELD_STRUCT_DESC: 30-inch square R.C.B.C. through the levee, 12.0 feet below the crown. Concrete "U" headwall on the waterward end. Flap gate on the waterward end. Concrete headwall on the landward end. (USACE-1967). This entry matches the Drainage or Irrigation Structure referenced in O&M manual (HLM 29.72). FS Date: 3/27/2014

Concrete headwall on WS toe.
