**Flood Control Project Maintenance  
Levee Inspections**  
**LMA District Cover Sheet**  
**Spring 2017 Levee Inspection Results**

**Lower San Joaquin Levee District**

Waterway			Bank	Unit Miles
Unit No. 01 San Joaquin River			Right	22.52
	Spring (March - May)	Summer (June - August)	(September - November) Fall	Winter (December - February)
Unit Maintenance Rating (Fall Only)				
Date of Inspection	4/17/2017 - 4/20/2017			
DWR Inspector	Richard Willoughby			
Accompanied By

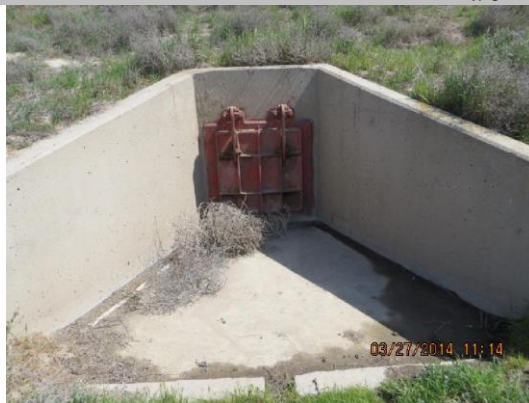
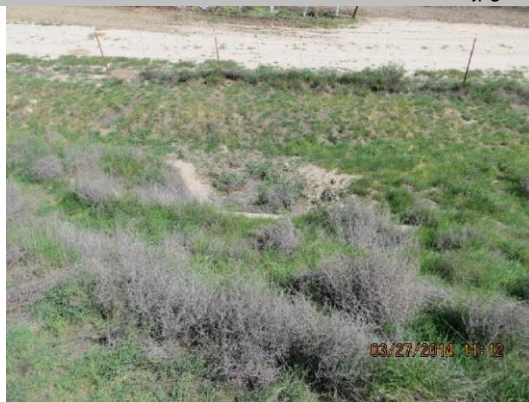
Photo 2 of 3 : UCIP\_SP\_2017\_39631\_59426.jpg

FS\_ID:39631  
DS\_ID:19754  
EP\_NO: N/A  
Repair Type: Non-Urgent  
Crossing Status: Found  
UCIP Comments: Dense vegetation limits the inspector's visibility to identify signs of pipe failure (leaks) along the landward slope. Recommend removing vegetation along pipe alignment to conduct proper inspection of structure.  
FIELD\_STRUCT\_DESC: 30-inch square R.C.B.C. through the levee, 12.0 feet below the crown. Concrete "U" headwall on the waterward end. Flap gate on the waterward end. Concrete headwall on the landward end. (USACE-1967). This entry matches the Drainage or Irrigation Structure referenced in O&M manual (HLM 29.72).  
FS Date: 3/27/2014

Flapgate on Concrete headwall at WS toe.

Concrete headwall on LS toe.

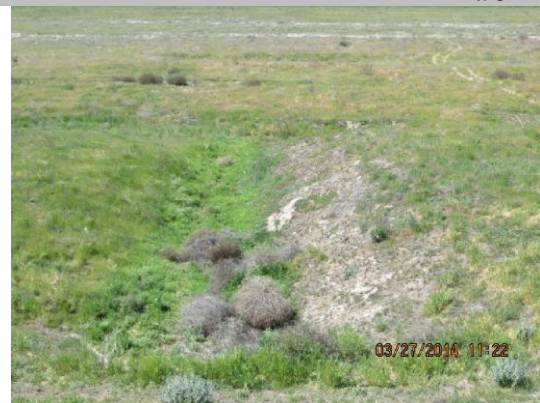
Photo 1 of 3 : UCIP\_SP\_2017\_39632\_59430.jpg

Comment Code					
Inspector Comment					
FS_ID:39632 DS_ID:19696 EP_NO: N/A Repair Type: Non-Urgent Crossing Status: Found UCIP Comments: Dense vegetation limits the inspector's visibility to identify signs of pipe failure (leaks) along the landward slope. Recommend removing vegetation along pipe alignment to conduct proper inspection of structure. FIELD_STRUCT_DESC: 30-inch square stormdrain R.C.B.C. through the levee, 13.1 feet below the crown. Concrete "U", headwall on the waterward end. Flap gate on the waterward end. Concrete headwall on the landward end. (USACE-1967). This entry matches the Drainage or Irrigation Structure referenced in O&M manual (HLM 30.04). FS Date: 3/27/2014

Concrete headwall on WS toe.

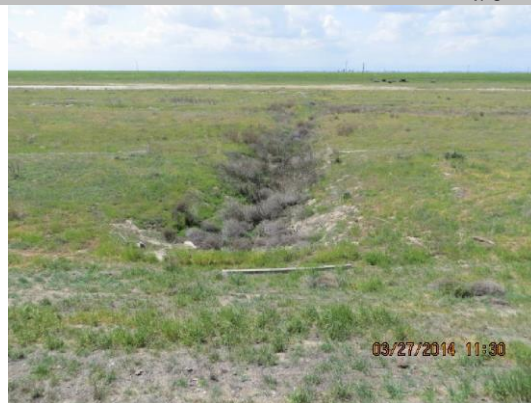
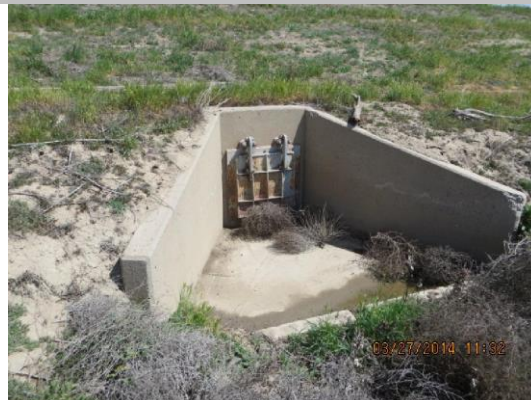
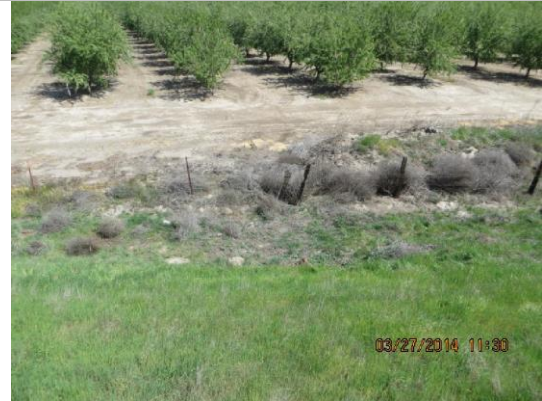
Photo 1 of 3 : UCIP\_SP\_2017\_39633\_59435.jpg

Concrete headwall on WS toe.

Flapgate on Concrete headwall at WS toe.

Item	DWR UCIP LMA Responsibility			37.004212 °		37.004212 °
				-120.419178 °		-120.419178 °
DWR ID						
Comment Code						
Inspector Comment						
FS_ID:39633						
DS_ID:19697						
EP_NO: N/A						
Repair Type: Non-Urgent						
Crossing Status: Found						
UCIP Comments: Some debris buildup at LS toe. Dense vegetation limits the inspector's visibility to identify signs of pipe failure (leaks) along the landward slope. Recommend removing vegetation along pipe alignment to conduct proper inspection of structure.						
FIELD_STRUCT_DESC: 30-inch square R.C.B.C. stormdrain through the levee, 13.3 feet below the crown. Concrete "U" headwall on the waterward end. Flap gate on the waterward end. Concrete headwall on the landward end. (USACE-1967). This entry matches the Drainage or Irrigation Structure referenced in O&M manual (HLM 30.96).						
FS Date: 3/27/2014

Concrete headwall on LS toe.

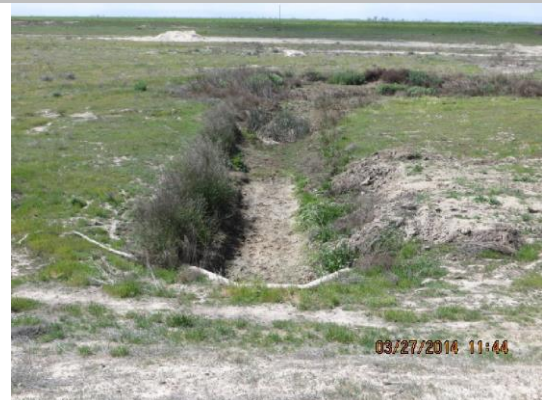
Photo 1 of 3 : UCIP\_SP\_2017\_39643\_59439.jpg

Comment Code					
Inspector Comment					
FS_ID:39643					
DS_ID:19698					
EP_NO: N/A					
Repair Type: Non-Urgent					
Crossing Status: Found					
UCIP Comments: Excess vegetation buildup at inlet on LS toe. Dense vegetation limits the inspector's visibility to identify signs of pipe failure (leaks) along the landward slope. Recommend removing vegetation along pipe alignment to conduct proper inspection of structure.					
FIELD_STRUCT_DESC: 30-inch square R.C.B.C. stormdrain through levee, 13.4 feet below crown. Concrete "U" headwall on waterward end. Flap gate on waterward end. Concrete headwall on landward end. (USACE-1967). This entry matches the Drainage or Irrigation Structure referenced in O&M manual (HLM 31.19).					
FS Date: 3/27/2014

Concrete headwall on WS toe.

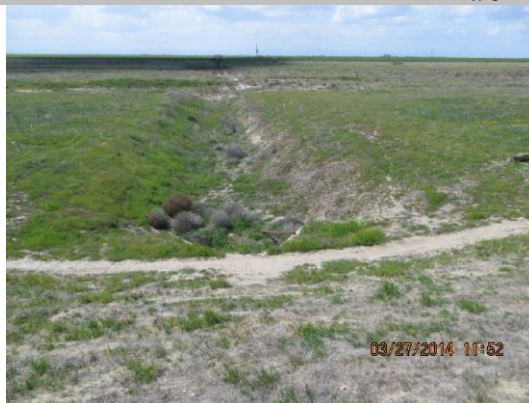
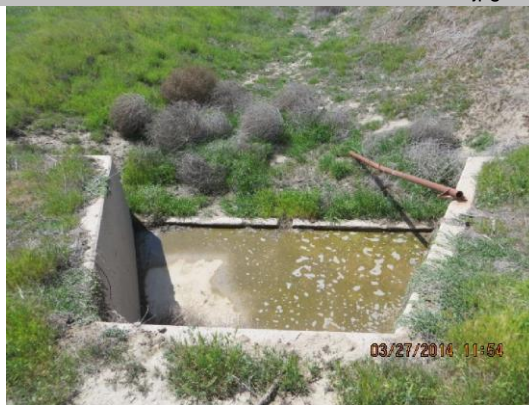
Photo 1 of 3 : UCIP\_SP\_2017\_39644\_59444.jpg

LM Start	31.74	Rating **	A/W	Issue No.	1396
LM End	31.74	Issue Type +	Ma	Location *	LS
Category	Supplemental			GPS Latitude/Longitude	
				Start	End
Item	DWR UCIP LMA Responsibility			36.997001 °	36.997001 °
				-120.410991 °	-120.410991 °
DWR ID					
Comment Code					
Inspector Comment					
FS_ID:39644					
DS_ID:19699					
EP_NO: N/A					
Repair Type: No Action Needed					
Crossing Status: Found					
UCIP Comments:					
FIELD_STRUCT_DESC: 48x36-inch R.C.B.C. stormdrain through the levee, 14.5 feet below the crown. Concrete "U" headwall on both ends. Flap gate on the waterward end. (USACE-1967). This entry matches the Drainage or Irrigation Structure referenced in O&M manual (HLM 31.64).					
FS Date: 3/27/2014

Concrete headwall on WS toe.

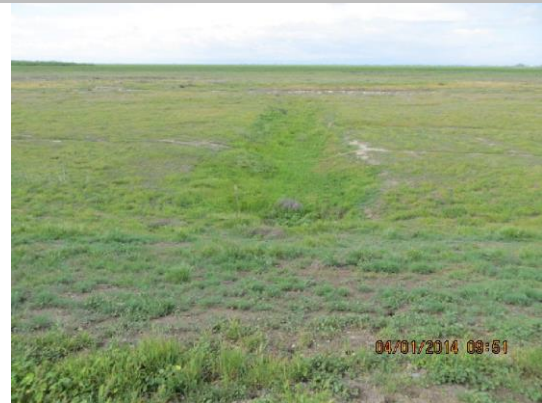
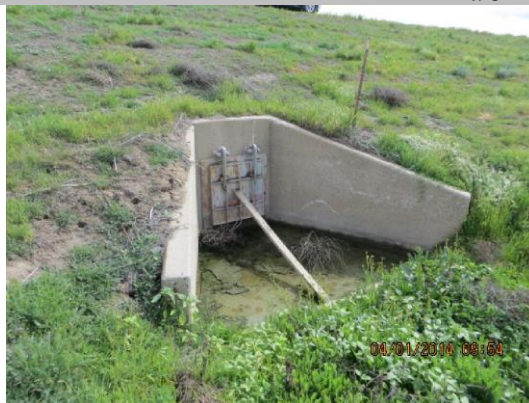
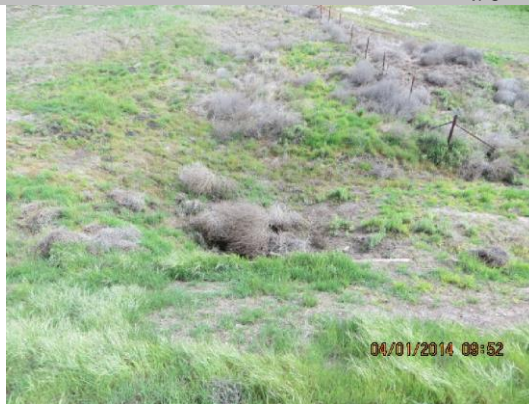
Photo 1 of 3 : UCIP\_SP\_2017\_39645\_59686.jpg

Concrete headwall at channel on WS toe.

Item	DWR UCIP LMA Responsibility			36.995029 °	36.995029 °	
				-120.408914 °	-120.408914 °	
DWR ID						
Comment Code						
Inspector Comment						
FS_ID:39645						
DS_ID:19700						
EP_NO: N/A						
Repair Type: Non-Urgent						
Crossing Status: Found						
UCIP Comments: Dense vegetation limits the inspector's visibility to identify signs of pipe failure (leaks) along the landward slope.						
Recommend removing vegetation along pipe alignment to conduct proper inspection of structure.						
FIELD_STRUCT_DESC: 30-inch square R.C.B.C. through the levee, 13.0 feet below the crown. Concrete "U" headwall on the waterward end. Flap gate on the waterward end. Concrete headwall on the landward end with flashboard attachment. (USACE-1967). This entry matches the Drainage or Irrigation Structure referenced in O&M manual (HLM 31.71).						
FS Date: 4/1/2014

Flapgate on Concrete headwall at channel on WS toe.

Concrete headwall on LS toe.

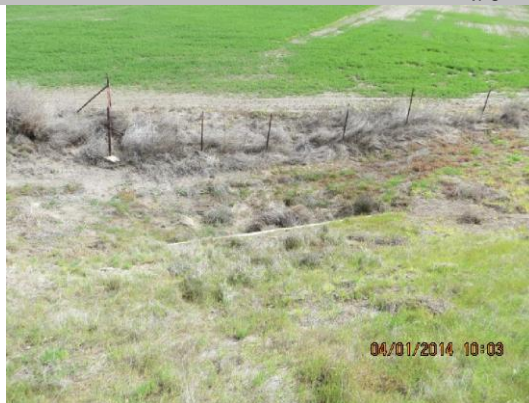
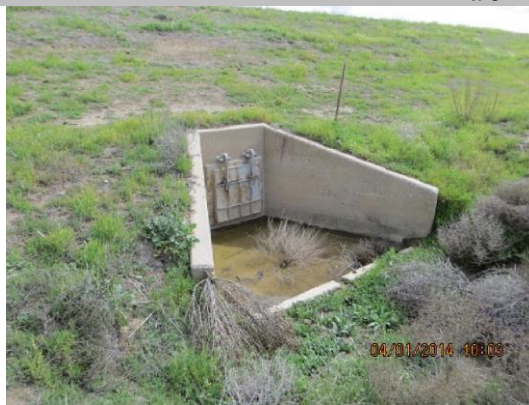
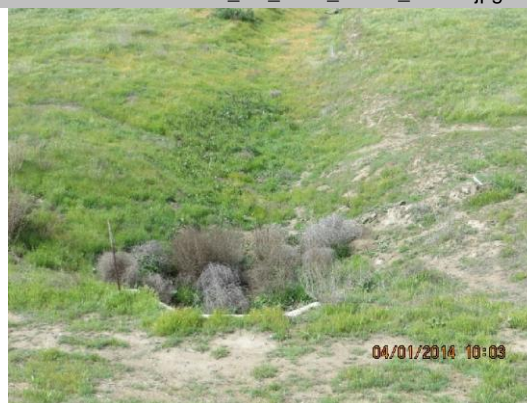
Photo 1 of 3 : UCIP\_SP\_2017\_39646\_59690.jpg

LM Start	32.32	Rating **	M	Issue No.	1398
LM End	32.32	Issue Type +	Ma	Location *	LS
Category	Supplemental			GPS Latitude/Longitude	
				Start	End
Item	DWR UCIP LMA Responsibility			36.989435 °	36.989435 °
				-120.402626 °	-120.402626 °
DWR ID					
Comment Code					
Inspector Comment					
FS_ID:39646 DS_ID:19701 EP_NO: N/A Repair Type: Non-Urgent Crossing Status: Found UCIP Comments: Some silt buildup inside culvert. FIELD_STRUCT_DESC: 30-inch square R.C.B.C. through the levee, 14.2 feet below the crown. Concrete "U" headwall on the waterward end. Flap gate on the waterward end. Concrete headwall on the landward end with flashboard attachment. (USACE-1967). This entry matches the Drainage or Irrigation Structure referenced in O&M manual (HLM 32.22). FS Date: 4/1/2014

Concrete headwall at inlet on LS toe.

Flapgate on Concrete headwall at WS toe.

Concrete headwall at outlet on WS toe.

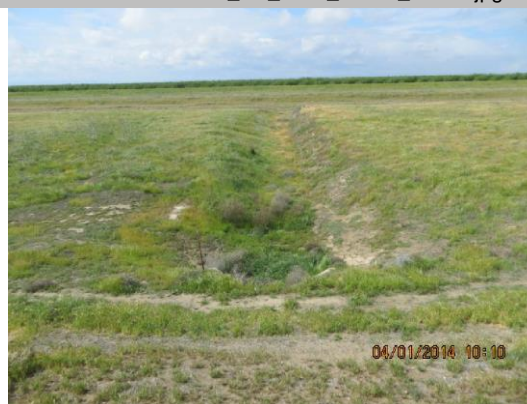
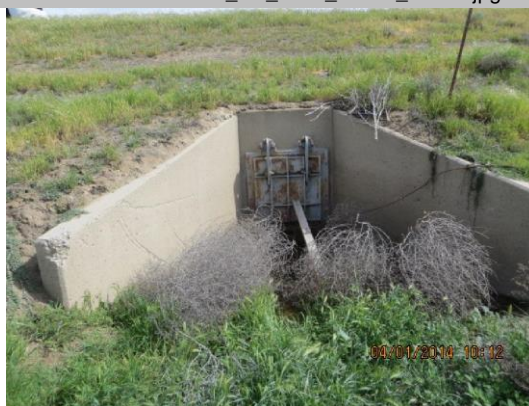
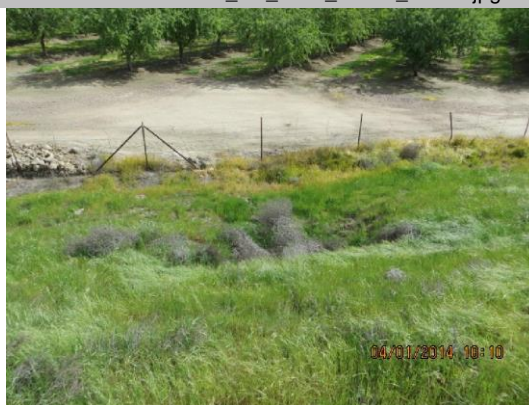
Photo 1 of 3 : UCIP\_SP\_2017\_39647\_59697.jpg

Comment Code					
Inspector Comment					
FS_ID:39647					
DS_ID:19702					
EP_NO: N/A					
Repair Type: Non-Urgent					
Crossing Status: Found					
UCIP Comments: Dense vegetation limits the inspector's visibility to identify signs of pipe failure (leaks) along the landward slope. Recommend removing vegetation along pipe alignment to conduct proper inspection of structure. Debris buildup blocking landward headwall--recommend contacting owner to clear debris.					
FIELD_STRUCT_DESC: 30-inch square R.C.B.C. through the levee, 12.2 feet below the crown. Concrete "U" headwall on the waterward end. Flap gate on the waterward end. Concrete headwall on the landward end. (USACE-1967). This entry matches the Drainage or Irrigation Structure referenced in O&M manual (HLM 33.01).					
FS Date: 4/1/2014

Concrete headwall at WS toe.

Flapgate on Concrete headwall at WS toe.

Concrete headwall at inlet on LS toe.

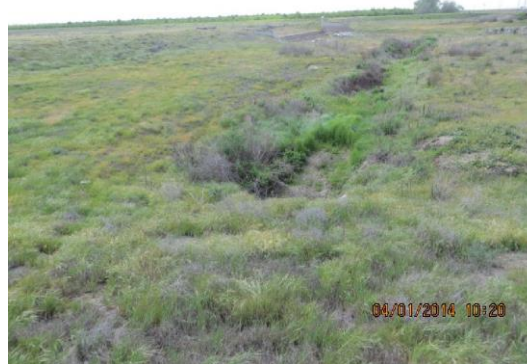
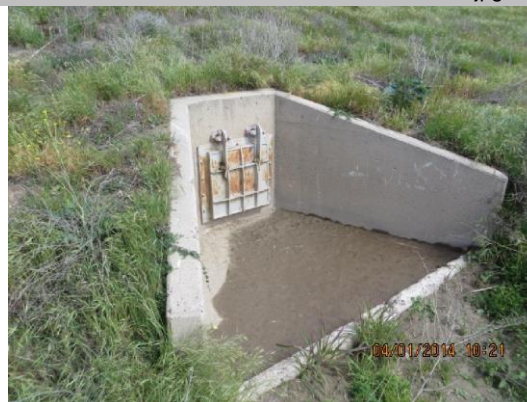
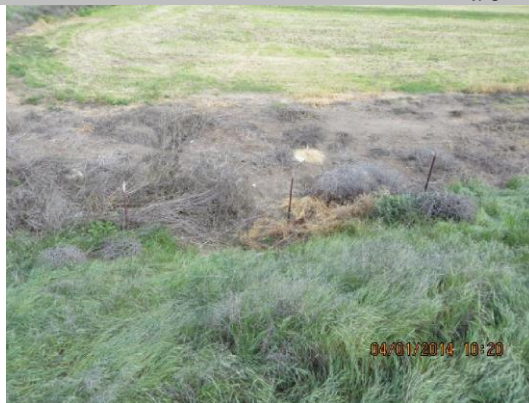
Photo 1 of 3 : UCIP\_SP\_2017\_39648\_59701.jpg

Concrete headwall at WS toe.

Flapgate on Concrete headwall at WS toe.

Item	DWR UCIP LMA Responsibility			36.976808 °	36.976808 °	
				-120.382593 °	-120.382593 °	
DWR ID						
Comment Code						
Inspector Comment						
FS_ID:39648 DS_ID:19703 EP_NO: N/A Repair Type: Non-Urgent Crossing Status: Found UCIP Comments: Dense vegetation limits the inspector's visibility to identify signs of pipe failure (leaks) along the slopes. Recommend removing vegetation along pipe alignment to conduct proper inspection of structure. FIELD_STRUCT_DESC: 30-inch square R.C.B.C. through the levee, 13.9 feet below the crown. Concrete "U" headwall on the waterward end. Flap gate on the waterward end. Concrete headwall on the landward end. (USACE-1967). This entry matches the Drainage or Irrigation Structure referenced in O&M manual (HLM 33.72). FS Date: 4/1/2014

Concrete headwall at LS toe.

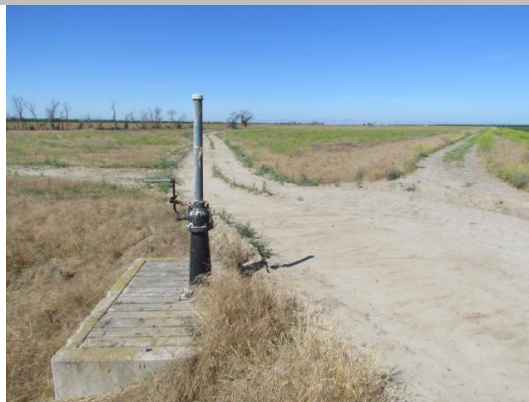
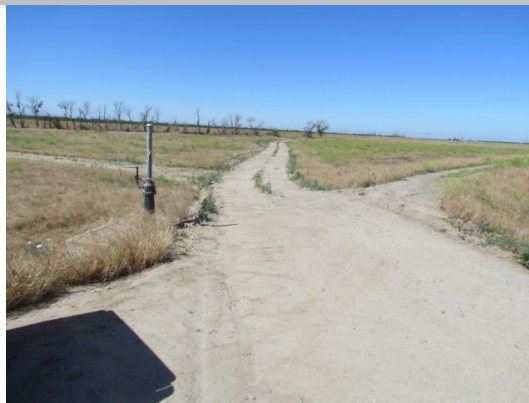
Photo 1 of 4 : SP\_2017\_NA0010\_123\_11\_20170417\_00006.jpg

LM Start	34.61	Rating **	M	Issue No.	11
LM End	34.61	Issue Type +	En	Location *	WS
Category	Earthen Levee			GPS Latitude/Longitude	
				Start	End
Item	Encroachments			36.978555 °	36.978555 °
				-120.368467 °	-120.368467 °
DWR ID	DWR_NA0010_05_s_2012_11				
Comment Code					
RA : Ramp					
Inspector Comment					
Unauthorized ramp on waterside slope. Landowner cut unauthorized ramp on waterside slope and levee crown.

Looking west at ramp on waterward slope.

Looking west at cut on levee crown.

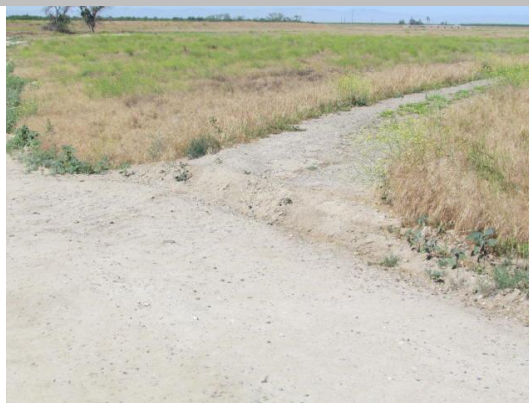
Photo 3 of 4 : SP\_2017\_NA0010\_123\_11\_20170417\_00008.jpg

Looking at cut on levee crown.

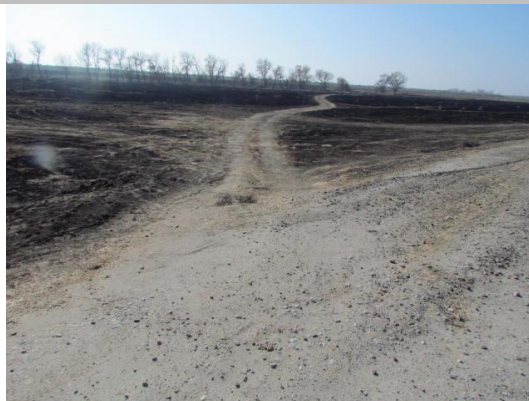
Photo 4 of 4 : SP\_2017\_NA0010\_123\_11\_20170417\_00009.jpg

Looking southwest at unauthorized ramp on waterward slope. (2015)

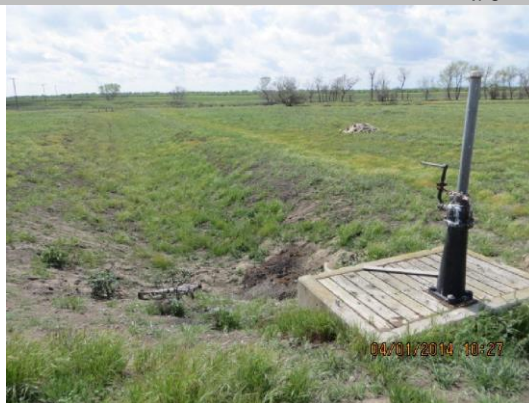
Photo 1 of 3 : UCIP\_SP\_2017\_39649\_59706.jpg

FS\_ID:39649  
DS\_ID:19755  
EP\_NO: N/A  
Repair Type: Non-Urgent  
Crossing Status: Found  
UCIP Comments: Dense vegetation limits the inspector's visibility to identify signs of pipe failure (leaks) along the landward slope. Recommend removing vegetation along pipe alignment to conduct proper inspection of structure. Debris buildup visible on waterward headwall--recommend contacting owner to clear pipe.  
FIELD\_STRUCT\_DESC: 36-inch square R.C.B.C. through the levee, 9.7 feet below the crown. Slide gate in 56"X91" concrete riser unit on the waterward slope. Concrete "U" headwalls on both ends. Landside channel cobble revetted for 8.0 feet. (USACE-1967). [Chowchilla Canal Irrigation Structure] This entry matches the Drainage or Irrigation Structure referenced in O&M manual (HLM 34.51).  
FS Date: 4/1/2014

Slide gate in concrete riser on WS shoulder.

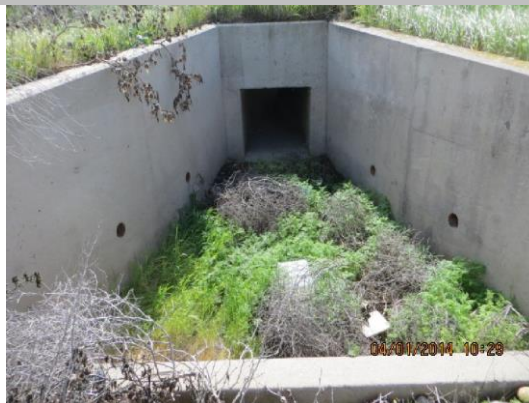
Photo 2 of 3 : UCIP\_SP\_2017\_39649\_59704.jpg

Concrete headwall at LS toe.

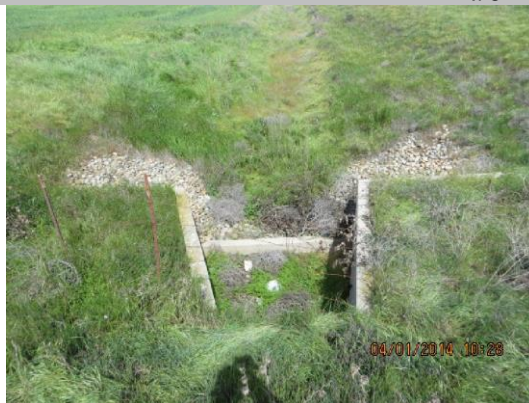
Photo 3 of 3 : UCIP\_SP\_2017\_39649\_59705.jpg

Item	DWR UCIP Field Study			36.978593 °		36.978593 °
				-120.368511 °		-120.368511 °
DWR ID						
Comment Code						
Inspector Comment						
FS_ID:39649						
DS_ID:19755						
EP_NO: N/A						
Repair Type: Non-Urgent						
Crossing Status: Found						
UCIP Comments: Dense vegetation limits the inspector's visibility to identify signs of pipe failure (leaks) along the landward slope.						
Recommend removing vegetation along pipe alignment to conduct proper inspection of structure. Debris buildup visible on waterward headwall--recommend contacting owner to clear pipe.						
FIELD_STRUCT_DESC: 36-inch square R.C.B.C. through the levee, 9.7 feet below the crown. Slide gate in 56"X91" concrete riser unit on the waterward slope. Concrete "U" headwalls on both ends. Landside channel cobble revetted for 8.0 feet. (USACE-1967). [Chowchilla Canal Irrigation Structure] This entry matches the Drainage or Irrigation Structure referenced in O&M manual (HLM 34.51).

Concrete headwall at LS toe.

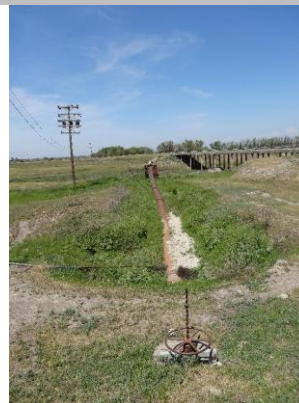
Photo 1 of 3 : UCIP\_SP\_2017\_39463\_66341.jpg

LM Start	0.66	Rating **	M	Issue No.	1213
LM End	0.66	Issue Type +	En	Location *	WS
Category	Supplemental			GPS Latitude/Longitude	
				Start	End
Item	DWR UCIP Field Study			37.271444 °	37.271444 °
				-120.815835 °	-120.815835 °
DWR ID					
Comment Code					
Inspector Comment					
FS_ID:39463 DS_ID:19815 EP_NO: N/A Repair Type: Non-Urgent Crossing Status: Found UCIP Comments: Need to contact owner. Sediment buildup on landward side. Recommend removing sediment buildup on landward toe. FIELD_STRUCT_DESC: 24-inch CM pipe through levee, 7.2 feet below crown. Slide gate inside 36-inch CM pipe riser in the waterward slope. Pump on concrete structure in channel. Concrete headwall on both ends. (USACE-1967). This entry matches the Drainage or Irrigation Structure referenced in O&M manual (HLM 0.74). FS Date: 4/18/2014

View of waterward side.

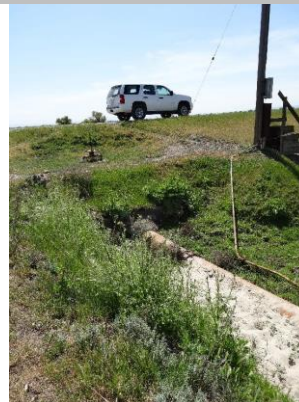
Photo 2 of 3 : UCIP\_SP\_2017\_39463\_66343.jpg

View of slope on waterward side.

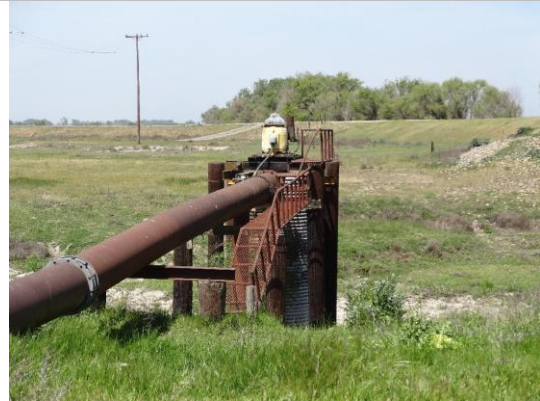
Photo 3 of 3 : UCIP\_SP\_2017\_39463\_66342.jpg

LM Start	0.66	Rating **	M	Issue No.	1213 (cont)
LM End	0.66	Issue Type +	En	Location *	WS
Category	Supplemental			GPS Latitude/Longitude	
				Start	End
Item	DWR UCIP Field Study			37.271444 °	37.271444 °
				-120.815835 °	-120.815835 °
DWR ID					
Comment Code					
Inspector Comment					
FS_ID:39463 DS_ID:19815 EP_NO: N/A Repair Type: Non-Urgent Crossing Status: Found UCIP Comments: Need to contact owner. Sediment buildup on landward side. Recommend removing sediment buildup on landward toe. FIELD_STRUCT_DESC: 24-inch CM pipe through levee, 7.2 feet below crown. Slide gate inside 36-inch CM pipe riser in the waterward slope. Pump on concrete structure in channel. Concrete headwall on both ends. (USACE-1967). This entry matches the Drainage or Irrigation Structure referenced in O&M manual (HLM 0.74). FS Date: 4/18/2014

Pump station visible on waterward side.

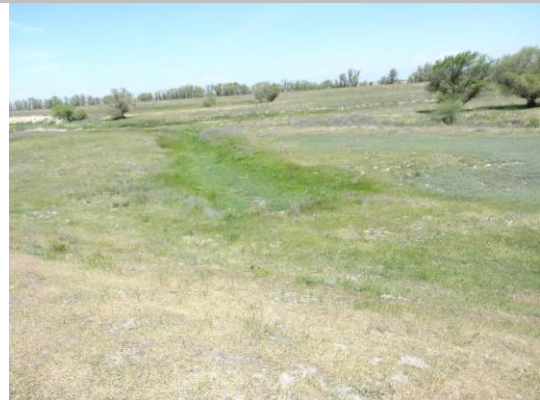
Photo 1 of 3 : UCIP\_SP\_2017\_36565\_66346.jpg

LM Start	0.78	Rating **	M	Issue No.	1214
LM End	0.78	Issue Type +	Ma	Location *	WS
Category	Supplemental			GPS Latitude/Longitude	
				Start	End
Item	DWR UCIP LMA Responsibility			37.270460 °	37.270460 °
				-120.814290 °	-120.814290 °
DWR ID					
Comment Code					
Inspector Comment					
FS_ID:36565					
DS_ID:19816					
EP_NO: N/A					
Repair Type: Non-Urgent					
Crossing Status: Found					
UCIP Comments: Landward side blocked--need to contact owner to determine status of crossing.					
FIELD_STRUCT_DESC: 24-inch CM pipe through levee, 16.2 feet below crown. Flap gate on the waterward end. Concrete "U" headwall on both ends. (USACE-1967). This entry matches the Drainage or Irrigation Structure referenced in O&M manual (HLM 0.86).					
FS Date: 4/18/2014

Overview of waterward side.

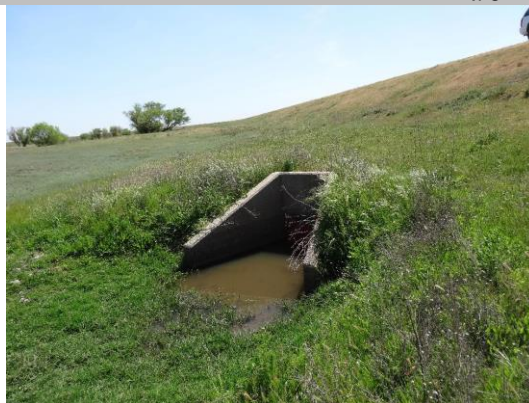
Photo 2 of 3 : UCIP\_SP\_2017\_36565\_66345.jpg

LM Start	0.78	Rating **	M	Issue No.	1214 (cont)
LM End	0.78	Issue Type +	Ma	Location *	WS
Category	Supplemental			GPS Latitude/Longitude	
				Start	End
Item	DWR UCIP LMA Responsibility			37.270460 °	37.270460 °
				-120.814290 °	-120.814290 °
DWR ID					
Comment Code					
Inspector Comment					
FS_ID:36565 DS_ID:19816 EP_NO: N/A Repair Type: Non-Urgent Crossing Status: Found UCIP Comments: Landward side blocked--need to contact owner to determine status of crossing. FIELD_STRUCT_DESC: 24-inch CM pipe through levee, 16.2 feet below crown. Flap gate on the waterward end. Concrete "U" headwall on both ends. (USACE-1967). This entry matches the Drainage or Irrigation Structure referenced in O&M manual (HLM 0.86). FS Date: 4/18/2014

Concrete structure located on waterward toe.

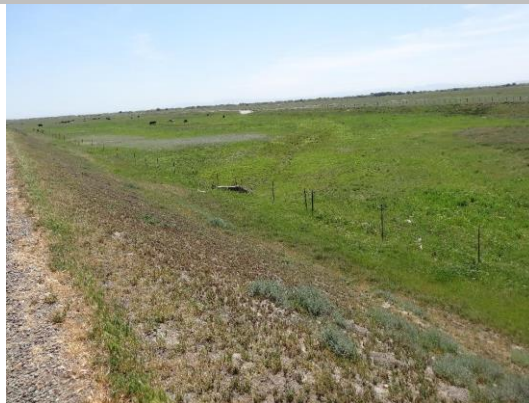
Photo 3 of 3 : UCIP\_SP\_2017\_36565\_66344.jpg

View of landward side.

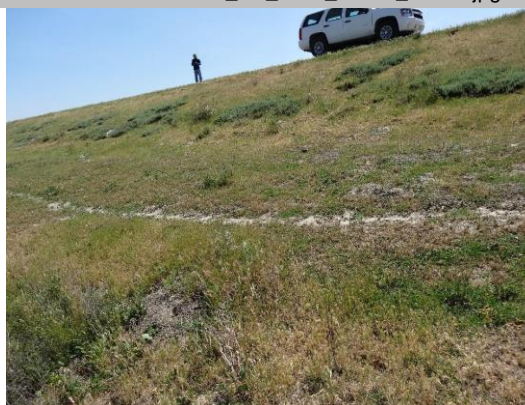
Photo 1 of 3 : UCIP\_SP\_2017\_36566\_66348.jpg

LM Start	1.87	Rating **	M	Issue No.	1215
LM End	1.87	Issue Type +	Ma	Location *	LS
Category	Supplemental			GPS Latitude/Longitude	
				Start	End
Item	DWR UCIP LMA Responsibility			37.259312 °	37.259312 °
				-120.802863 °	-120.802863 °
DWR ID					
Comment Code					
Inspector Comment					
FS_ID:36566					
DS_ID:19817					
EP_NO: N/A					
Repair Type: Non-Urgent					
Crossing Status: Found					
UCIP Comments: No access was available to landward side due to fence. Recommend removing some of the vegetation on waterward toe.					
FIELD_STRUCT_DESC: 24-inch CM pipe through levee, 13.5 feet below crown. Flap gate on the waterward end. Concrete headwall at both ends. (USACE-1967). This entry matches the Drainage or Irrigation Structure referenced in O&M manual (HLM 1.95).					
FS Date: 4/18/2014

View of waterward side.

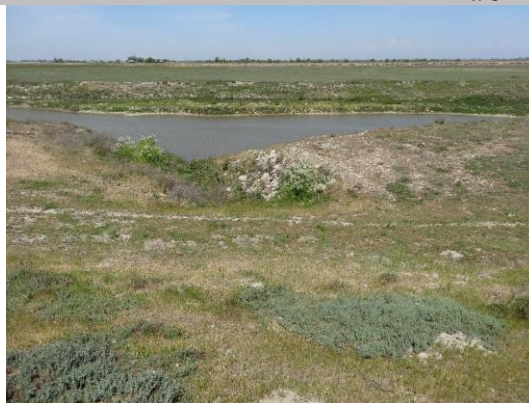
Photo 2 of 3 : UCIP\_SP\_2017\_36566\_66350.jpg

LM Start	1.87	Rating **	M	Issue No.	1215 (cont)	
LM End	1.87	Issue Type +	Ma	Location *	LS	
Category	Supplemental			GPS Latitude/Longitude		
				Start		End
Item	DWR UCIP LMA Responsibility			37.259312 °	37.259312 °	
				-120.802863 °	-120.802863 °	
DWR ID						
Comment Code						
Inspector Comment						
FS_ID:36566						
DS_ID:19817						
EP_NO: N/A						
Repair Type: Non-Urgent						
Crossing Status: Found						
UCIP Comments: No access was available to landward side due to fence. Recommend removing some of the vegetation on waterward toe.						
FIELD_STRUCT_DESC: 24-inch CM pipe through levee, 13.5 feet below crown. Flap gate on the waterward end. Concrete headwall at both ends. (USACE-1967). This entry matches the Drainage or Irrigation Structure referenced in O&M manual (HLM 1.95).						
FS Date: 4/18/2014

View of waterward side.

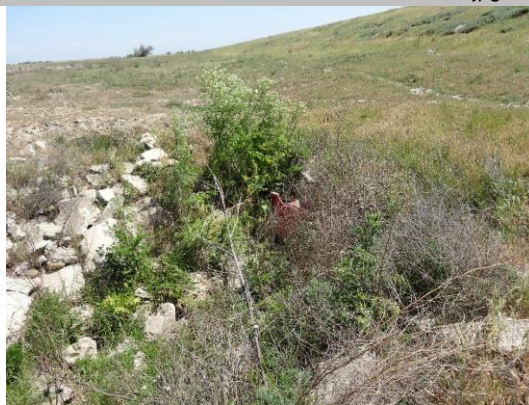
Photo 3 of 3 : UCIP\_SP\_2017\_36566\_66349.jpg

Flap gate visible on waterward side.

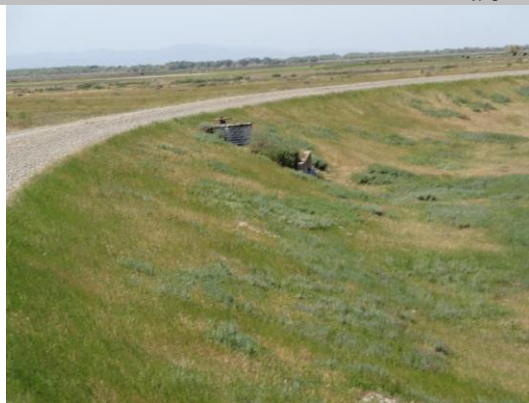
Photo 1 of 3 : UCIP\_SP\_2017\_39464\_66354.jpg

LM Start	2.53	Rating **	M	Issue No.	1216
LM End	2.53	Issue Type +	Ma	Location *	LS
Category	Supplemental			GPS Latitude/Longitude	
				Start	End
Item	DWR UCIP LMA Responsibility			37.252948 °	37.252948 °
				-120.794352 °	-120.794352 °
DWR ID					
Comment Code					
Inspector Comment					
FS_ID:39464 DS_ID:19818 EP_NO: N/A Repair Type: Non-Urgent Crossing Status: Found UCIP Comments: Need to contact owner. Sediment buildup in pipe visible on landward side. FIELD_STRUCT_DESC: 36-inch CM pipe through levee, 6.9 feet below crown. Slide gate in 48-inch CM pipe riser in the waterward slope. Concrete headwall on both ends. (USACE-1967). This entry matches the Drainage or Irrigation Structure referenced in O&M manual (HLM 2.61). FS Date: 4/18/2014

View of waterward side.

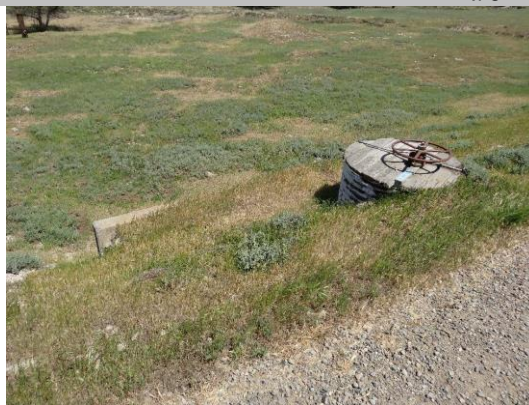
Photo 2 of 3 : UCIP\_SP\_2017\_39464\_66357.jpg

View of waterward side.

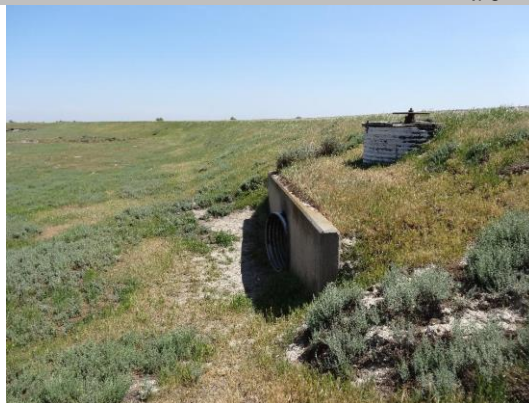
Photo 3 of 3 : UCIP\_SP\_2017\_39464\_66356.jpg

LM Start	2.53	Rating **	M	Issue No.	1216 (cont)	
LM End	2.53	Issue Type +	Ma	Location *	LS	
Category	Supplemental			GPS Latitude/Longitude		
				Start		End
Item	DWR UCIP LMA Responsibility			37.252948 °		37.252948 °
				-120.794352 °		-120.794352 °
DWR ID						
Comment Code						
Inspector Comment						
FS_ID:39464 DS_ID:19818 EP_NO: N/A Repair Type: Non-Urgent Crossing Status: Found UCIP Comments: Need to contact owner. Sediment buildup in pipe visible on landward side. FIELD_STRUCT_DESC: 36-inch CM pipe through levee, 6.9 feet below crown. Slide gate in 48-inch CM pipe riser in the waterward slope. Concrete headwall on both ends. (USACE-1967). This entry matches the Drainage or Irrigation Structure referenced in O&M manual (HLM 2.61). FS Date: 4/18/2014

CMP riser, concrete headwall, and pipe visible on waterward side.

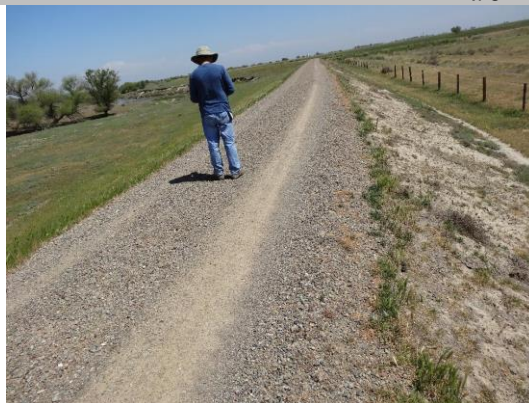
Photo 1 of 3 : UCIP\_SP\_2017\_36568\_66362.jpg

LM Start	2.57	Rating **	M	Issue No.	1217
LM End	2.57	Issue Type +	Ma	Location *	WS
Category	Supplemental			GPS Latitude/Longitude	
				Start	End
Item	DWR UCIP LMA Responsibility			37.252743 °	37.252743 °
				-120.793756 °	-120.793756 °
DWR ID					
Comment Code					
Inspector Comment					
FS_ID:36568 DS_ID:19819 EP_NO: N/A Repair Type: Non-Urgent Crossing Status: Found UCIP Comments: Dense vegetation limits the inspector's visibility to identify signs of pipe condition on landward toe--headwall blocked by dense vegetation. Recommend removing vegetation from landward toe. FIELD_STRUCT_DESC: 24-inch CM pipe through levee, 9.2 feet below crown. Flap gate on the waterward end. Concrete headwall on both ends. (USACE-1967). This entry matches the Drainage or Irrigation Structure referenced in O&M manual (HLM 2.65). FS Date: 4/18/2014

Overview of levee crown at crossing.

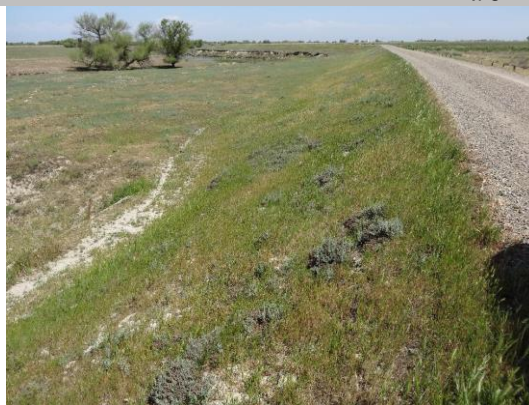
Photo 2 of 3 : UCIP\_SP\_2017\_36568\_66360.jpg

View of waterward side.

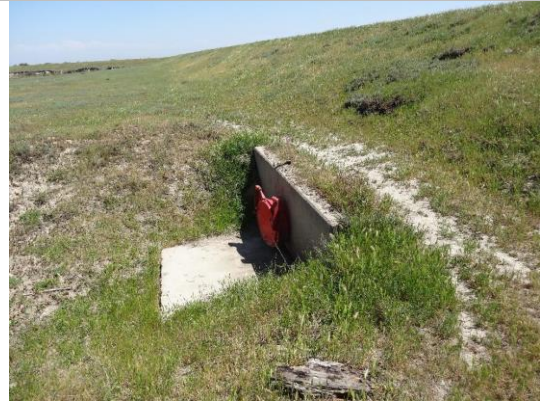
Photo 3 of 3 : UCIP\_SP\_2017\_36568\_66359.jpg

LM Start	2.57	Rating **	M	Issue No.	1217 (cont)
LM End	2.57	Issue Type +	Ma	Location *	WS
Category	Supplemental			GPS Latitude/Longitude	
				Start	End
Item	DWR UCIP LMA Responsibility			37.252743 °	37.252743 °
				-120.793756 °	-120.793756 °
DWR ID					
Comment Code					
Inspector Comment					
FS_ID:36568 DS_ID:19819 EP_NO: N/A Repair Type: Non-Urgent Crossing Status: Found UCIP Comments: Dense vegetation limits the inspector's visibility to identify signs of pipe condition on landward toe--headwall blocked by dense vegetation. Recommend removing vegetation from landward toe. FIELD_STRUCT_DESC: 24-inch CM pipe through levee, 9.2 feet below crown. Flap gate on the waterward end. Concrete headwall on both ends. (USACE-1967). This entry matches the Drainage or Irrigation Structure referenced in O&M manual (HLM 2.65). FS Date: 4/18/2014

View of concrete headwall, flap gate, and concrete apron located on waterward side.

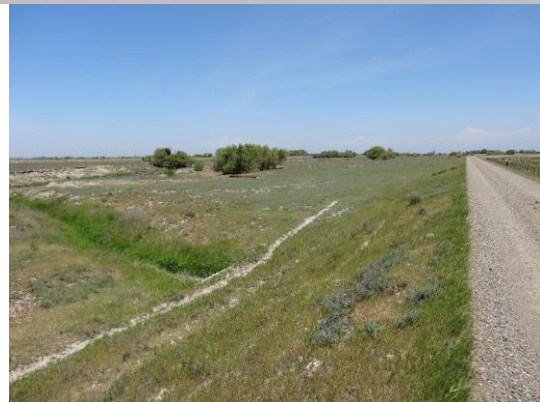
Photo 1 of 3 : UCIP\_SP\_2017\_36569\_66369.jpg

LM Start	2.77	Rating **	M	Issue No.	1218
LM End	2.77	Issue Type +	Ma	Location *	WS
Category	Supplemental			GPS Latitude/Longitude	
				Start	End
Item	DWR UCIP LMA Responsibility			37.253020 °	37.253020 °
				-120.790219 °	-120.790219 °
DWR ID					
Comment Code					
Inspector Comment					
FS_ID:36569 DS_ID:19820 EP_NO: N/A Repair Type: Non-Urgent Crossing Status: Found UCIP Comments: Dense vegetation limits the inspector's visibility to identify signs of pipe condition on landward toe--headwall blocked by dense vegetation. Recommend removing vegetation from landward toe. FIELD_STRUCT_DESC: 24-inch CM pipe through levee, 10.5 feet below crown. Flap gate on the waterward end. Concrete headwall on both ends. (USACE-1967). This entry matches the Drainage or Irrigation Structure referenced in O&M manual (HLM 2.85). FS Date: 4/18/2014

View of waterward side.

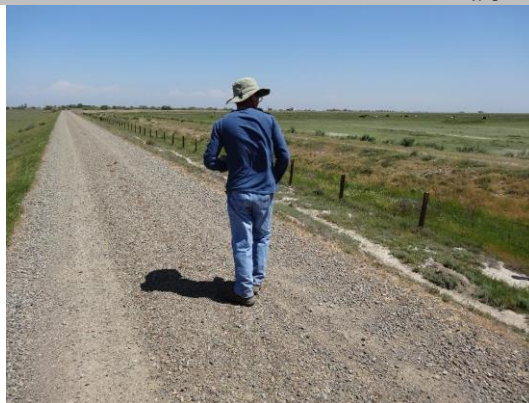
Photo 2 of 3 : UCIP\_SP\_2017\_36569\_66368.jpg

LM Start	2.77	Rating **	M	Issue No.	1218 (cont)
LM End	2.77	Issue Type +	Ma	Location *	WS
Category	Supplemental			GPS Latitude/Longitude	
				Start	End
Item	DWR UCIP LMA Responsibility			37.253020 °	37.253020 °
				-120.790219 °	-120.790219 °
DWR ID					
Comment Code					
Inspector Comment					
FS_ID:36569 DS_ID:19820 EP_NO: N/A Repair Type: Non-Urgent Crossing Status: Found UCIP Comments: Dense vegetation limits the inspector's visibility to identify signs of pipe condition on landward toe--headwall blocked by dense vegetation. Recommend removing vegetation from landward toe. FIELD_STRUCT_DESC: 24-inch CM pipe through levee, 10.5 feet below crown. Flap gate on the waterward end. Concrete headwall on both ends. (USACE-1967). This entry matches the Drainage or Irrigation Structure referenced in O&M manual (HLM 2.85). FS Date: 4/18/2014

Overview of levee crown at crossing.

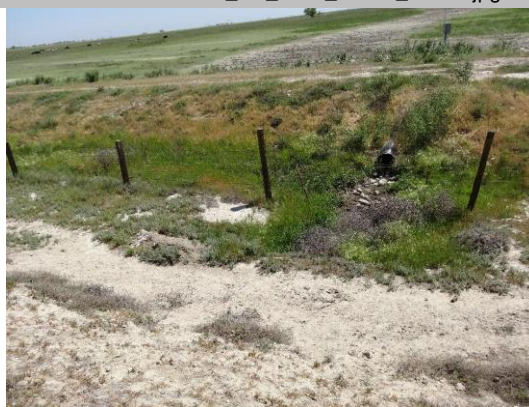
Photo 3 of 3 : UCIP\_SP\_2017\_36569\_66372.jpg

View of landward side.

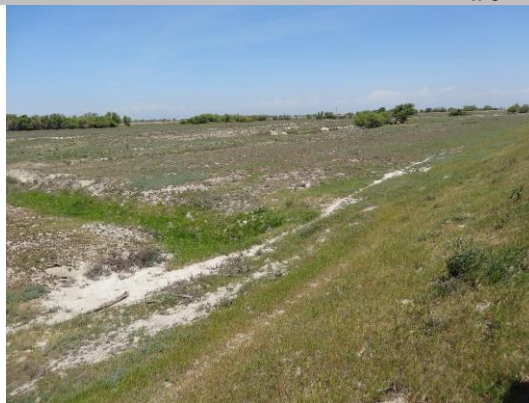
Photo 1 of 3 : UCIP\_SP\_2017\_36583\_66381.jpg

LM Start	3.01	Rating **	M	Issue No.	1219
LM End	3.01	Issue Type +	Ma	Location *	WS
Category	Supplemental			GPS Latitude/Longitude	
				Start	End
Item	DWR UCIP LMA Responsibility			37.253811 °	37.253811 °
				-120.786059 °	-120.786059 °
DWR ID					
Comment Code					
Inspector Comment					
FS_ID:36583 DS_ID:19821 EP_NO: N/A Repair Type: Non-Urgent Crossing Status: Found UCIP Comments: Dense vegetation limits the inspector's visibility to identify signs of pipe condition on landward toe--headwall blocked by dense vegetation. Recommend removing vegetation from landward toe. FIELD_STRUCT_DESC: 24 inch CM pipe through levee, 11.2 feet below crown. Flap gate on the waterward end. Concrete headwall on both ends. (USACE-1967). This entry matches the Drainage or Irrigation Structure referenced in O&M manual (HLM 3.09). FS Date: 4/18/2014

View of waterward side.

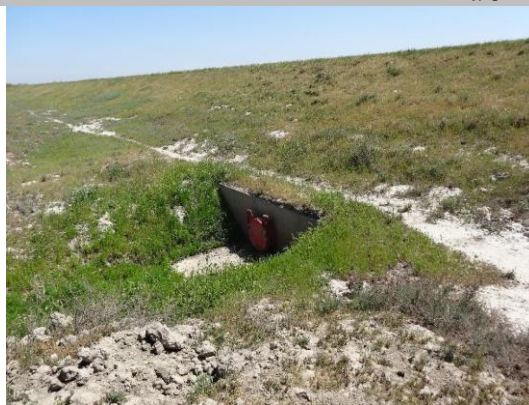
Photo 2 of 3 : UCIP\_SP\_2017\_36583\_66380.jpg

Flap gate and concrete headwall visible on waterward side.

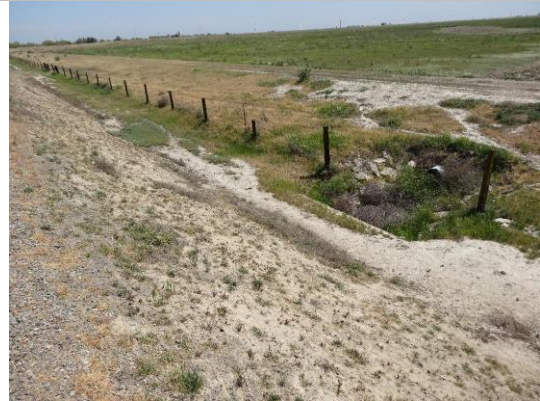
Photo 3 of 3 : UCIP\_SP\_2017\_36583\_66383.jpg

Item	DWR UCIP LMA Responsibility			37.253811 °	37.253811 °	
				-120.786059 °	-120.786059 °	
DWR ID						
Comment Code						
Inspector Comment						
FS_ID:36583						
DS_ID:19821						
EP_NO: N/A						
Repair Type: Non-Urgent						
Crossing Status: Found						
UCIP Comments: Dense vegetation limits the inspector's visibility to identify signs of pipe condition on landward toe--headwall blocked by dense vegetation. Recommend removing vegetation from landward toe.						
FIELD_STRUCT_DESC: 24 inch CM pipe through levee, 11.2 feet below crown. Flap gate on the waterward end. Concrete headwall on both ends. (USACE-1967). This entry matches the Drainage or Irrigation Structure referenced in O&M manual (HLM 3.09).						
FS Date: 4/18/2014

View of landward side.

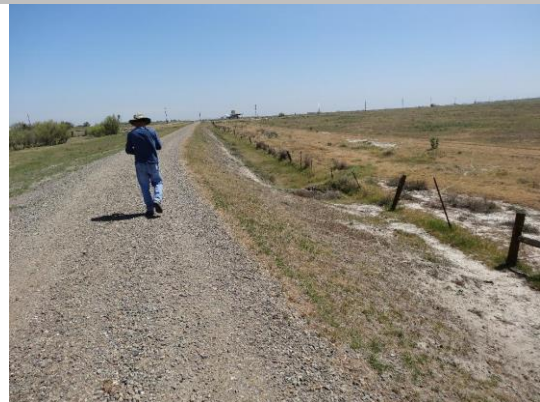
Photo 1 of 3 : UCIP\_SP\_2017\_36584\_66384.jpg

LM Start	3.21	Rating **	M	Issue No.	1220
LM End	3.21	Issue Type +	Ma	Location *	WS
Category	Supplemental			GPS Latitude/Longitude	
				Start	End
Item	DWR UCIP LMA Responsibility			37.253513 °	37.253513 °
				-120.782509 °	-120.782509 °
DWR ID					
Comment Code					
Inspector Comment					
FS_ID:36584 DS_ID:19822 EP_NO: N/A Repair Type: Non-Urgent Crossing Status: Found UCIP Comments: Dense vegetation limits the inspector's visibility to identify signs of pipe condition on waterward slope and landward toe (headwall blocked by dense vegetation). Recommend removing vegetation from landward toe. FIELD_STRUCT_DESC: 24-inch CM pipe through levee, 10.4 feet below crown. Flap gate on the waterward end. Concrete headwall on both ends. (USACE-1967). This entry matches the Drainage or Irrigation Structure referenced in O&M manual (HLM 3.29). FS Date: 4/18/2014

Overview of levee crown and landward side.

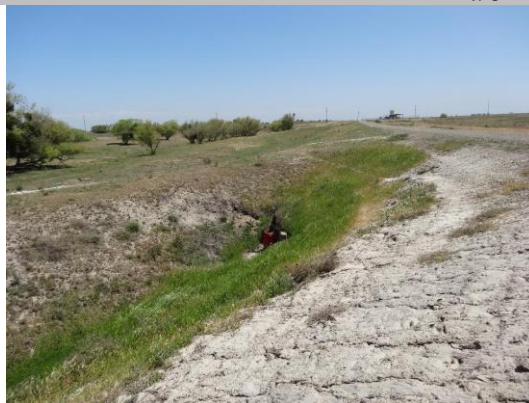
Photo 2 of 3 : UCIP\_SP\_2017\_36584\_66386.jpg

View of waterward side.

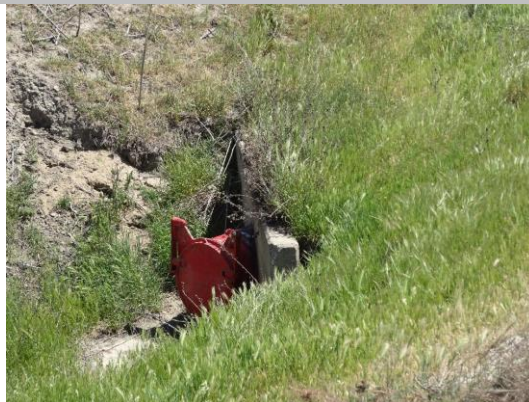
Photo 3 of 3 : UCIP\_SP\_2017\_36584\_66385.jpg

Crossing goes through the levee at an angle. Flap gate visible on waterward side.

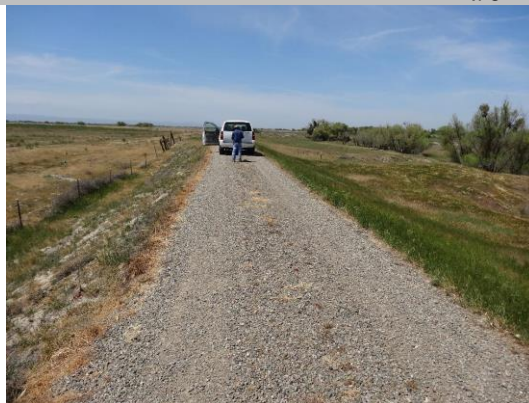
Photo 1 of 3 : UCIP\_SP\_2017\_36585\_66389.jpg

Comment Code					
Inspector Comment					
FS_ID:36585 DS_ID:19823 EP_NO: N/A Repair Type: Non-Urgent Crossing Status: Found UCIP Comments: Alignment of crossing unknown--altered crossing. No headwall found on landward side only siphon breaker found a short distance from landward toe. Tall grass observed on waterward slope and some burrow activity also noticed. Need to contact owner to determine alignment of crossing and status of crossing. FIELD_STRUCT_DESC: 36-inch CM pipe through levee, 15.7 feet below crown. Flap gate on the waterward end. Concrete "U" headwall on both ends. BM stamped 9770-152 on top of the headwall on the waterward side. (USACE-1967). This entry matches the Drainage or Irrigation Structure referenced in O&M manual (HLM 3.43). FS Date: 4/18/2014

Overview of levee crown at crossing.

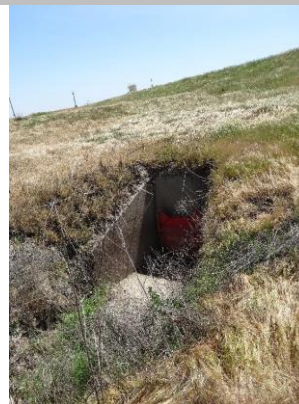
Photo 2 of 3 : UCIP\_SP\_2017\_36585\_66390.jpg

Flap gate and concrete headwall visible on waterward side.

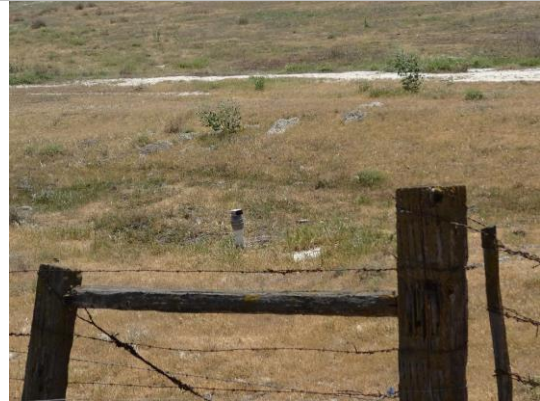
Photo 3 of 3 : UCIP\_SP\_2017\_36585\_66391.jpg

Comment Code					
Inspector Comment					
FS_ID:36585 DS_ID:19823 EP_NO: N/A Repair Type: Non-Urgent Crossing Status: Found UCIP Comments: Alignment of crossing unknown--altered crossing. No headwall found on landward side only siphon breaker found a short distance from landward toe. Tall grass observed on waterward slope and some burrow activity also noticed. Need to contact owner to determine alignment of crossing and status of crossing. FIELD_STRUCT_DESC: 36-inch CM pipe through levee, 15.7 feet below crown. Flap gate on the waterward end. Concrete "U" headwall on both ends. BM stamped 9770-152 on top of the headwall on the waterward side. (USACE-1967). This entry matches the Drainage or Irrigation Structure referenced in O&M manual (HLM 3.43). FS Date: 4/18/2014

View of landward side. No signs of concrete headwall only siphon breaker visible on landward side.

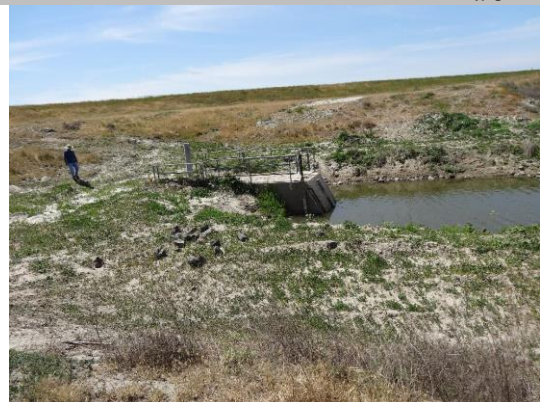
Photo 1 of 3 : UCIP\_SP\_2017\_39482\_71643.jpg

Comment Code					
Inspector Comment					
FS_ID:39482 DS_ID:19824 EP_NO: 6965 Repair Type: Non-Urgent Crossing Status: Indicator Found UCIP Comments: Description of structure does not match. Need to contact owner. Current description includes concrete platform, trash screen, and gage reading on waterward side. Metal box located on waterward shoulder. Large plant facility locate on landward side. FIELD_STRUCT_DESC: 16-inch steel discharge pipe through levee, 7.4 feet below crown. CM cutoff wall around pipe in center of levee. Siphon breaker on apex of pipe on landward levee shoulder. Pump on waterward side, with timber platform on waterward berm for support. Pipe exposed on both slopes. (Permit No. 6965-1971) FS Date: 4/10/2014

View of structure located on waterward side.

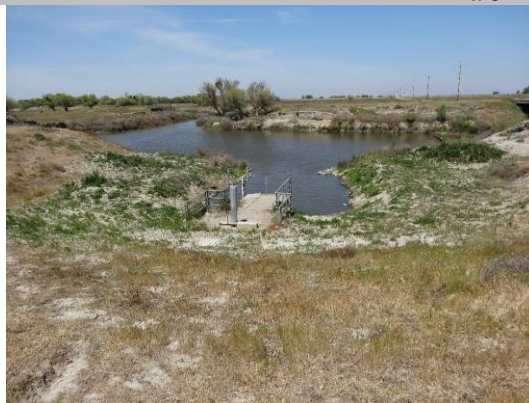
Photo 2 of 3 : UCIP\_SP\_2017\_39482\_71644.jpg

Item	DWR UCIP Field Study			37.251902 °		37.251902 °
				-120.779391 °		-120.779391 °
DWR ID						
Comment Code						
Inspector Comment						
FS_ID:39482 DS_ID:19824 EP_NO: 6965 Repair Type: Non-Urgent Crossing Status: Indicator Found UCIP Comments: Description of structure does not match. Need to contact owner. Current description includes concrete platform, trash screen, and gage reading on waterward side. Metal box located on waterward shoulder. Large plant facility locate on landward side. FIELD_STRUCT_DESC: 16-inch steel discharge pipe through levee, 7.4 feet below crown. CM cutoff wall around pipe in center of levee. Siphon breaker on apex of pipe on landward levee shoulder. Pump on waterward side, with timber platform on waterward berm for support. Pipe exposed on both slopes. (Permit No. 6965-1971) FS Date: 4/10/2014

View of waterward side.

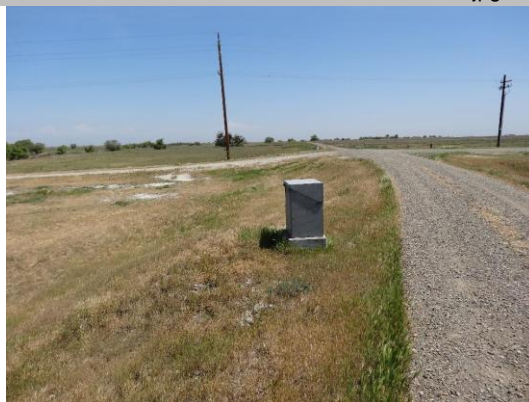
Photo 3 of 3 : UCIP\_SP\_2017\_39482\_71642.jpg

Metal box located on waterward shoulder.

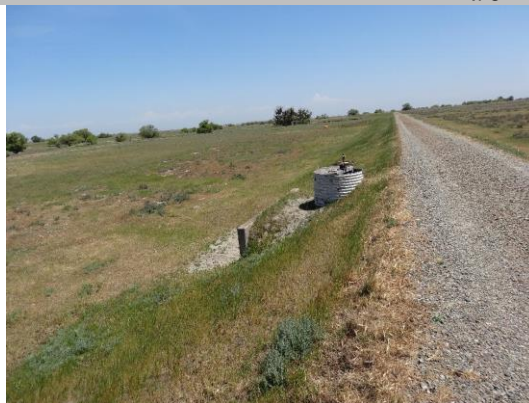
Photo 1 of 3 : UCIP\_SP\_2017\_39465\_66394.jpg

Comment Code					
Inspector Comment					
FS_ID:39465 DS_ID:19825 EP_NO: N/A Repair Type: Non-Urgent Crossing Status: Found UCIP Comments: Sediment buildup inside pipe visible from landward side. Excess soil is also present on landward toe partially blocking concrete headwall and inlet. Recommend removing soil from landward toe and clear buildup inside. FIELD_STRUCT_DESC: 36-inch CM pipe through the levee, 6.8 feet below crown. Slide gate in 48-inch CM pipe riser in the waterward slope. Concrete headwall on both ends. Pipe connects to 30-inch steel drainpipe on waterward side. Drainpipe extends to pump on waterward side, on support platform in channel. (USACE-1967). This entry matches the Drainage or Irrigation Structure referenced in O&M manual (HLM 3.54). Extension drainpipe and pump installed under Permit No. 12527 (1980). FS Date: 4/18/2014

View of waterward side--cmp riser and concrete headwall visible.

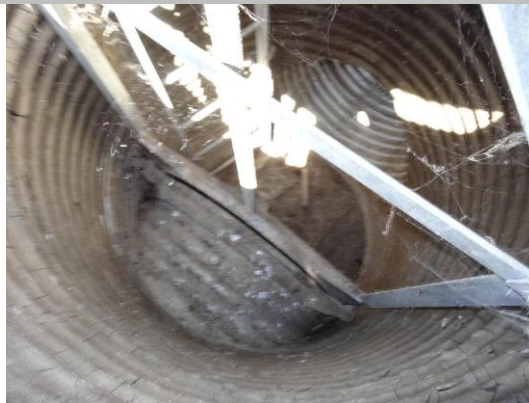
Photo 2 of 3 : UCIP\_SP\_2017\_39465\_66395.jpg

Inside view of cmp riser located on waterward slope.

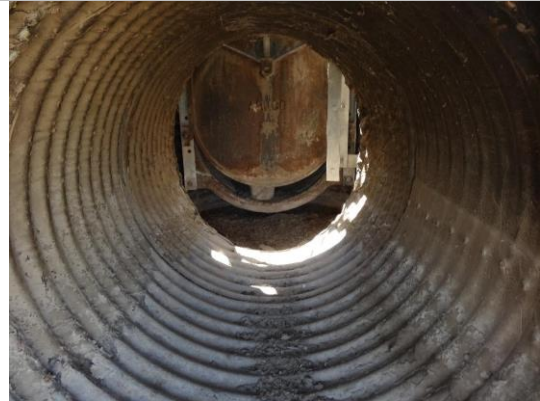
Photo 3 of 3 : UCIP\_SP\_2017\_39465\_66397.jpg

Comment Code					
Inspector Comment					
FS_ID:39465 DS_ID:19825 EP_NO: N/A Repair Type: Non-Urgent Crossing Status: Found UCIP Comments: Sediment buildup inside pipe visible from landward side. Excess soil is also present on landward toe partially blocking concrete headwall and inlet. Recommend removing soil from landward toe and clear buildup inside. FIELD_STRUCT_DESC: 36-inch CM pipe through the levee, 6.8 feet below crown. Slide gate in 48-inch CM pipe riser in the waterward slope. Concrete headwall on both ends. Pipe connects to 30-inch steel drainpipe on waterward side. Drainpipe extends to pump on waterward side, on support platform in channel. (USACE-1967). This entry matches the Drainage or Irrigation Structure referenced in O&M manual (HLM 3.54). Extension drainpipe and pump installed under Permit No. 12527 (1980). FS Date: 4/18/2014

Inside view of pipe from waterward side.

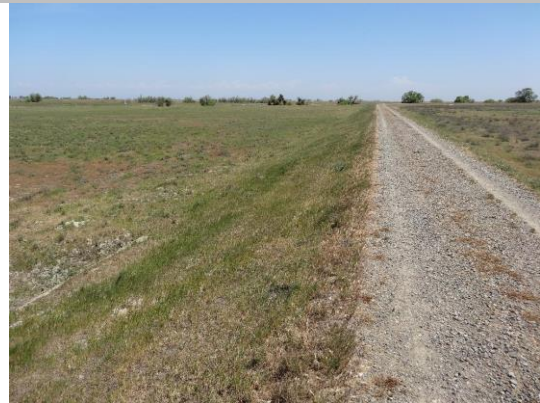
Photo 1 of 3 : UCIP\_SP\_2017\_39466\_66413.jpg

LM Start	3.69	Rating **	M	Issue No.	1224
LM End	3.69	Issue Type +	Ma	Location *	WS
Category	Supplemental			GPS Latitude/Longitude	
				Start	End
Item	DWR UCIP LMA Responsibility			37.251199 °	37.251199 °
				-120.774474 °	-120.774474 °
DWR ID					
Comment Code					
Inspector Comment					
FS_ID:39466 DS_ID:19826 EP_NO: N/A Repair Type: Non-Urgent Crossing Status: Found UCIP Comments: Sediment buildup inside crossing and is visible from landward side. Recommend clearing sediment buildup inside pipe and check wall integrity to determine condition. FIELD_STRUCT_DESC: 24-inch CM pipe through levee, 7.0 feet below crown. Flap gate on the waterward end. Concrete headwall on both ends. (USACE-1967). This entry matches the Drainage or Irrigation Structure referenced in O&M manual (HLM 3.77). FS Date: 4/18/2014

View of waterward side.

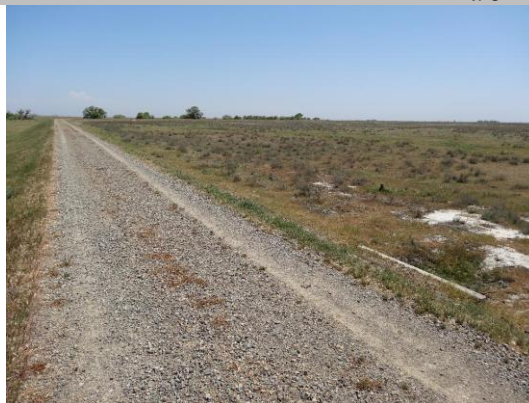
Photo 2 of 3 : UCIP\_SP\_2017\_39466\_66412.jpg

View of landward side.
