**Flood Control Project Maintenance  
Levee Inspections**  
**LMA District Cover Sheet**  
**Spring 2017 Levee Inspection Results**

**Lower San Joaquin Levee District**

Waterway			Bank	Unit Miles
Unit No. 01 San Joaquin River			Right	22.52
	Spring (March - May)	Summer (June - August)	(September - November) Fall	Winter (December - February)
Unit Maintenance Rating (Fall Only)				
Date of Inspection	4/17/2017 - 4/20/2017			
DWR Inspector	Richard Willoughby			
Accompanied By

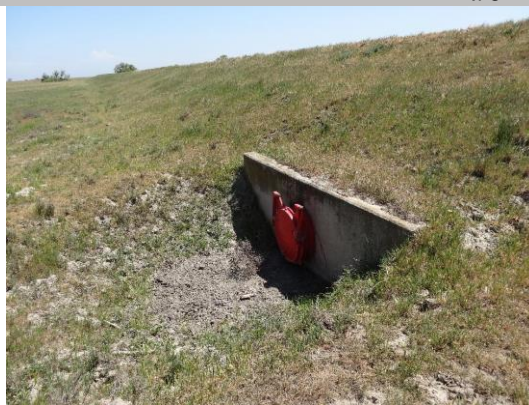
Photo 3 of 3 : UCIP\_SP\_2017\_39466\_66411.jpg

View of flap gate visible on waterward side.

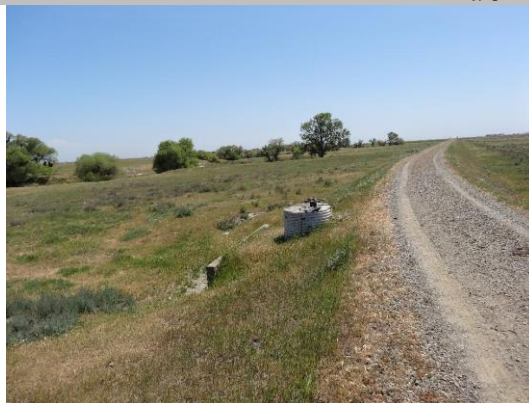
Photo 1 of 3 : UCIP\_SP\_2017\_39467\_66407.jpg

LM Start	3.89	Rating **	M	Issue No.	1225
LM End	3.89	Issue Type +	Ma	Location *	WS
Category	Supplemental			GPS Latitude/Longitude	
				Start	End
Item	DWR UCIP LMA Responsibility			37.250742 °	37.250742 °
				-120.771026 °	-120.771026 °
DWR ID					
Comment Code					
Inspector Comment					
FS_ID:39467 DS_ID:19827 EP_NO: N/A Repair Type: Non-Urgent Crossing Status: Found UCIP Comments: Sediment buildup inside crossing and is visible from landward side. Recommend clearing sediment buildup inside pipe and check wall integrity to determine condition. FIELD_STRUCT_DESC: 36-inch CM pipe through levee, 6.7 feet below crown. Slide gate in 48-inch CM pipe riser in the waterward slope. (USACE-1967). This entry matches the Drainage or Irrigation Structure referenced in O&M manual (HLM 3.97). FS Date: 4/18/2014

View of waterward side.

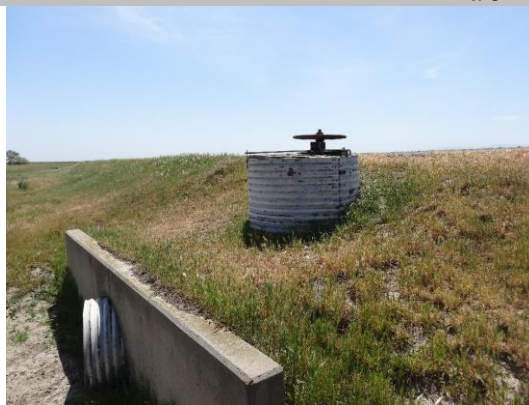
Photo 2 of 3 : UCIP\_SP\_2017\_39467\_66406.jpg

Slide gate inside CMP riser visible on waterward slope.

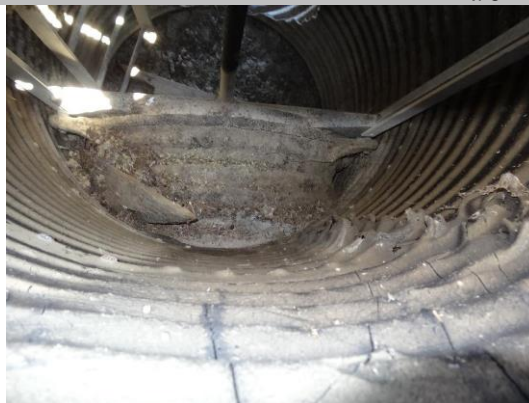
Photo 3 of 3 : UCIP\_SP\_2017\_39467\_66410.jpg

Inside view of CMP riser located on waterward side.

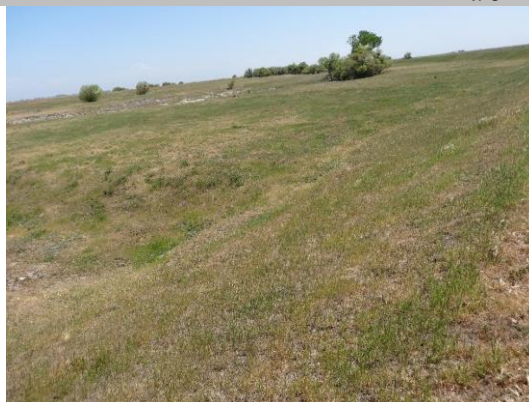
Photo 1 of 3 : UCIP\_SP\_2017\_36606\_66418.jpg

LM Start	4.09	Rating **	M	Issue No.	1226
LM End	4.09	Issue Type +	Ma	Location *	WS
Category	Supplemental			GPS Latitude/Longitude	
				Start	End
Item	DWR UCIP LMA Responsibility			37.248353 °	37.248353 °
				-120.768922 °	-120.768922 °
DWR ID					
Comment Code					
Inspector Comment					
FS_ID:36606 DS_ID:19828 EP_NO: N/A Repair Type: Non-Urgent Crossing Status: Found UCIP Comments: Dense vegetation limits the inspector's visibility to identify signs of pipe condition on landward toe--headwall blocked by dense vegetation. Recommend removing vegetation from landward toe. FIELD_STRUCT_DESC: 24-inch CM pipe through levee, 10.8 feet below crown. Flap gate on the waterward end. Concrete headwall on both ends. (USACE-1967). This entry matches the Drainage or Irrigation Structure referenced in O&M manual (HLM 4.17). FS Date: 4/18/2014

View of waterward side.

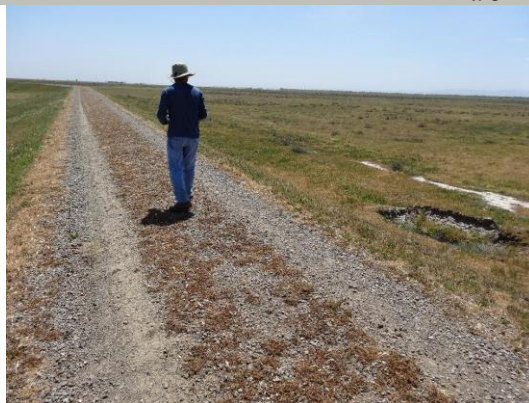
Photo 2 of 3 : UCIP\_SP\_2017\_36606\_66417.jpg

Overview of levee crown at crossing.

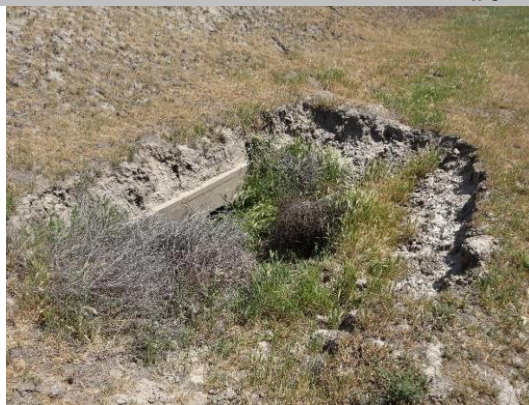
Photo 3 of 3 : UCIP\_SP\_2017\_36606\_66416.jpg

LM Start	4.09	Rating **	M	Issue No.	1226 (cont)
LM End	4.09	Issue Type +	Ma	Location *	WS
Category	Supplemental			GPS Latitude/Longitude	
				Start	End
Item	DWR UCIP LMA Responsibility			37.248353 °	37.248353 °
				-120.768922 °	-120.768922 °
DWR ID					
Comment Code					
Inspector Comment					
FS_ID:36606 DS_ID:19828 EP_NO: N/A Repair Type: Non-Urgent Crossing Status: Found UCIP Comments: Dense vegetation limits the inspector's visibility to identify signs of pipe condition on landward toe--headwall blocked by dense vegetation. Recommend removing vegetation from landward toe. FIELD_STRUCT_DESC: 24-inch CM pipe through levee, 10.8 feet below crown. Flap gate on the waterward end. Concrete headwall on both ends. (USACE-1967). This entry matches the Drainage or Irrigation Structure referenced in O&M manual (HLM 4.17). FS Date: 4/18/2014

Concrete headwall visible on landward side.

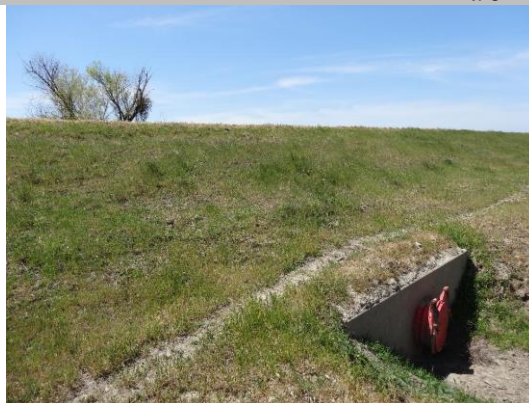
Photo 1 of 2 : UCIP\_SP\_2017\_36607\_66422.jpg

LM Start	4.33	Rating **	M	Issue No.	1227
LM End	4.33	Issue Type +	Ma	Location *	WS
Category	Supplemental			GPS Latitude/Longitude	
				Start	End
Item	DWR UCIP LMA Responsibility			37.246459 °	37.246459 °
				-120.765470 °	-120.765470 °
DWR ID					
Comment Code					
Inspector Comment					
FS_ID:36607 DS_ID:19829 EP_NO: N/A Repair Type: Non-Urgent Crossing Status: Found UCIP Comments: Dense vegetation limits the inspector's visibility to identify signs of pipe condition on landward toe--headwall blocked by dense vegetation. Recommend removing vegetation from landward toe. FIELD_STRUCT_DESC: 24-inch CM pipe through levee, 11.3 feet below crown. Flap gate on the waterward end. Concrete headwall on both ends. (USACE-1967). This entry matches the Drainage or Irrigation Structure referenced in O&M manual (HLM 4.41). FS Date: 4/18/2014

View of waterward side--concrete headwall and flap gate visible.

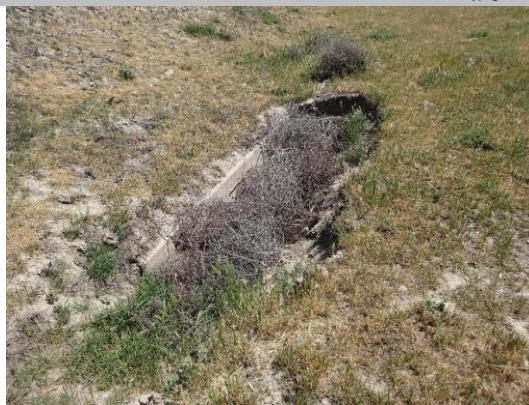
Photo 2 of 2 : UCIP\_SP\_2017\_36607\_66421.jpg

View of landward side--concrete headwall visible through dense vegetation.

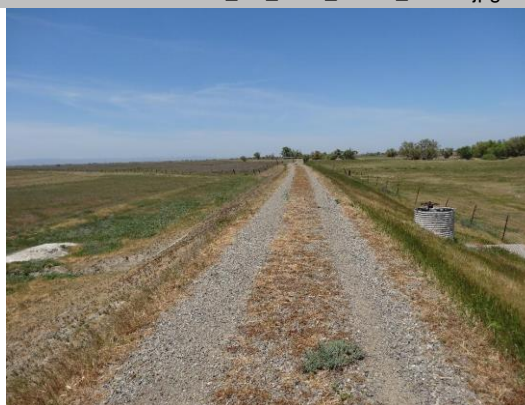
Photo 1 of 3 : UCIP\_SP\_2017\_39468\_66425.jpg

LM Start	4.62	Rating **	M	Issue No.	1228
LM End	4.62	Issue Type +	Ma	Location *	CR
Category	Supplemental			GPS Latitude/Longitude	
				Start	End
Item	DWR UCIP LMA Responsibility			37.243946 °	37.243946 °
				-120.761296 °	-120.761296 °
DWR ID					
Comment Code					
Inspector Comment					
FS_ID:39468 DS_ID:19830 EP_NO: N/A Repair Type: Non-Urgent Crossing Status: Found UCIP Comments: Sediment buildup inside crossing visible from landward side. Recommend clearing sediment buildup inside pipe and check wall integrity to determine condition. FIELD_STRUCT_DESC: 36-inch CM pipe through levee, 6.9 feet below crown. Slide gate in 48-inch CM pipe riser in the waterward slope. Concrete headwall on the landward end. Concrete saddle and apron on the waterward end. (USACE-1967). This entry matches the Drainage or Irrigation Structure referenced in O&M manual (HLM 4.70). FS Date: 4/18/2014

Overview of levee crown at crossing.

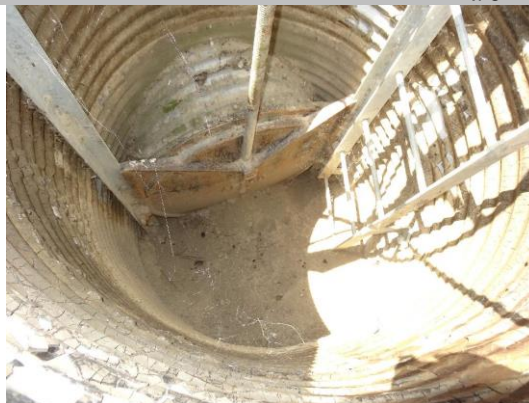
Photo 2 of 3 : UCIP\_SP\_2017\_39468\_66426.jpg

Inside view of CMP riser located on waterward.

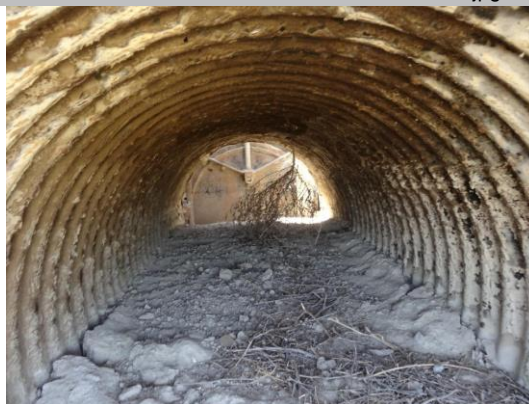
Photo 3 of 3 : UCIP\_SP\_2017\_39468\_66424.jpg

Inside view of pipe from waterward side.

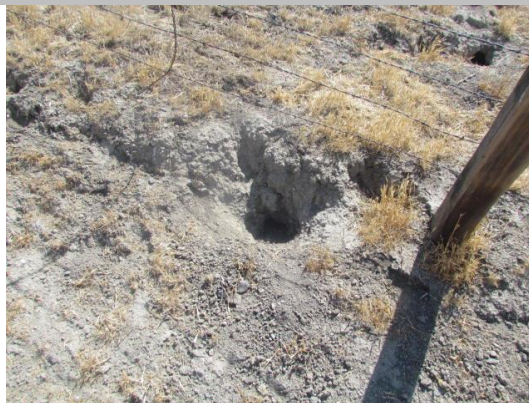
Photo 1 of 2 : SP\_2017\_NA0010\_124\_10\_20170417\_00010.jpg

LM Start	4.66	Rating **	M	Issue No.	10
LM End	4.66	Issue Type +	Ma	Location *	LS
Category	Earthen Levee			GPS Latitude/Longitude	
				Start	End
Item	Animal Control			37.243540 °	37.243540 °
				-120.760782 °	-120.760782 °
DWR ID	DWR_NA0010_06_s_2012_10				
Comment Code					
A3 : No rodents visible, but rodent burrows visible; need to backfill and compact or grout burrows.					
Inspector Comment					
Rodent holes next to fence post on landward slope.

Looking at rodent hole along fence line on landward slope.

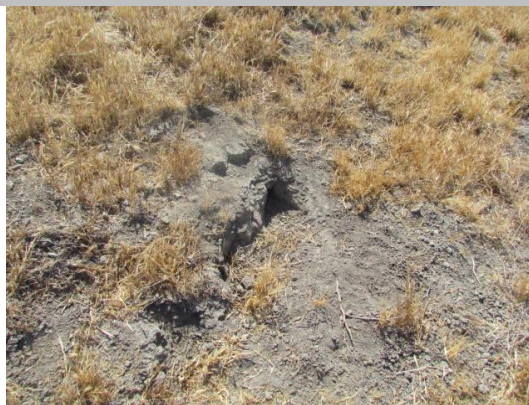
Photo 2 of 2 : SP\_2017\_NA0010\_124\_10\_20170417\_00011.jpg

Looking at typical rodent holes on landward slope.

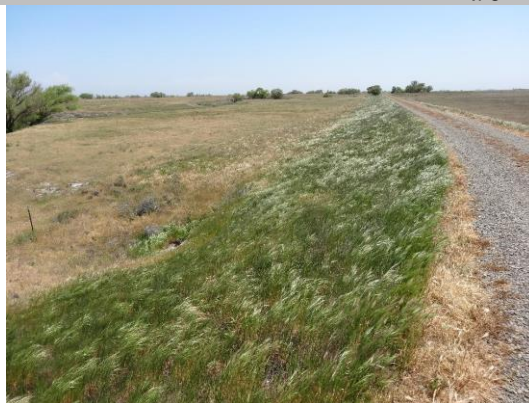
Photo 1 of 3 : UCIP\_SP\_2017\_36609\_66433.jpg

LM Start	4.67	Rating **	M	Issue No.	1229
LM End	4.67	Issue Type +	Ma	Location *	LS
Category	Supplemental			GPS Latitude/Longitude	
				Start	End
Item	DWR UCIP LMA Responsibility			37.243408 °	37.243408 °
				-120.760564 °	-120.760564 °
DWR ID					
Comment Code					
Inspector Comment					
FS_ID:36609 DS_ID:19831 EP_NO: N/A Repair Type: Non-Urgent Crossing Status: Found UCIP Comments: Need to contact owner. Recommend removing tall grass on landward toe to determine condition of crossing from landward side. FIELD_STRUCT_DESC: 24-inch CM pipe through levee, 11.8 feet below crown. Flap gate on the waterward end. Concrete headwall on both ends. (USACE-1967). This entry matches the Drainage or Irrigation Structure referenced in O&M manual (HLM 4.75). FS Date: 4/18/2014

View of waterward side.

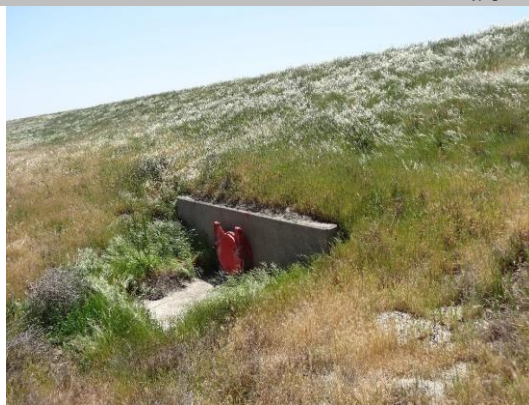
Photo 2 of 3 : UCIP\_SP\_2017\_36609\_66432.jpg

Flap gate, concrete headwall and apron visible on waterward toe.

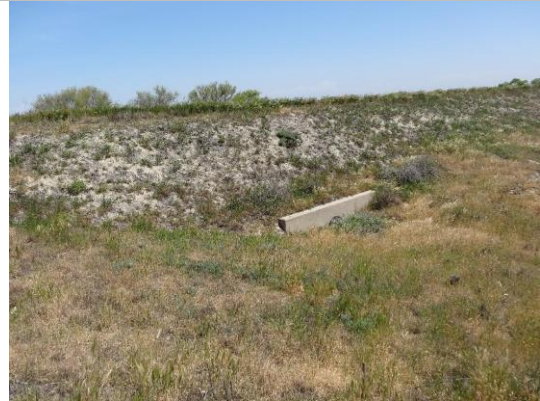
Photo 3 of 3 : UCIP\_SP\_2017\_36609\_66431.jpg

View of landward side.

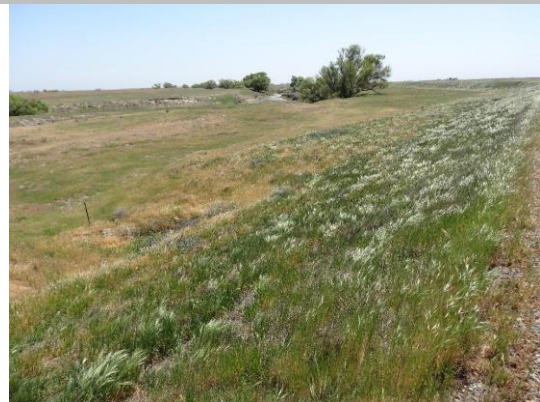
Photo 1 of 3 : UCIP\_SP\_2017\_36610\_66436.jpg

Comment Code					
Inspector Comment					
FS_ID:36610 DS_ID:19862 EP_NO: N/A Repair Type: Non-Urgent Crossing Status: Found UCIP Comments: Dense vegetation limits the inspector's visibility to identify signs of pipe failure (leaks) along the waterward slope. Recommend removing vegetation along waterward slope to conduct proper inspection of structure. Also recommend removing dense vegetation blocking landward headwall. FIELD_STRUCT_DESC: 24-inch CM pipe through levee, 10.8 feet below crown. Flap gate on the waterward end. Concrete headwall on both ends. (USACE-1967). This entry matches the Drainage or Irrigation Structure referenced in O&M manual (HLM 4.94). FS Date: 4/18/2014

View of waterward side.

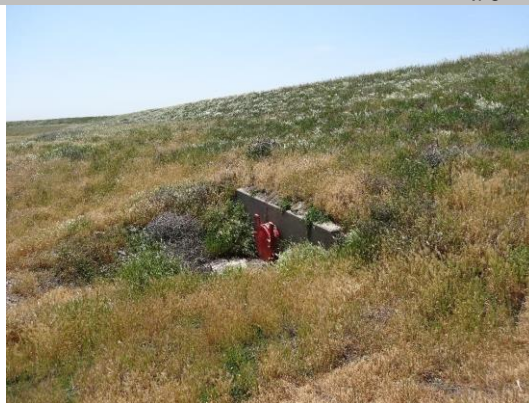
Photo 2 of 3 : UCIP\_SP\_2017\_36610\_66438.jpg

View of flap gate, concrete headwall and apron located on waterward side.

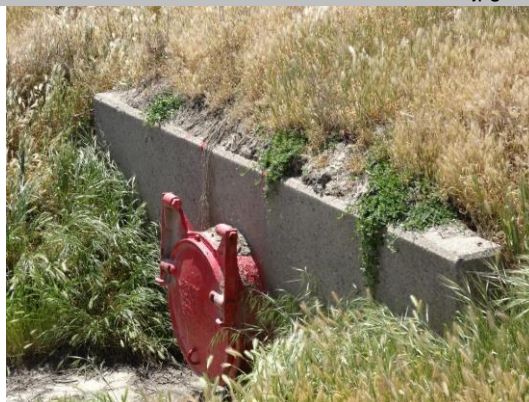
Photo 3 of 3 : UCIP\_SP\_2017\_36610\_66437.jpg

Close up of flap gate located on waterward side.

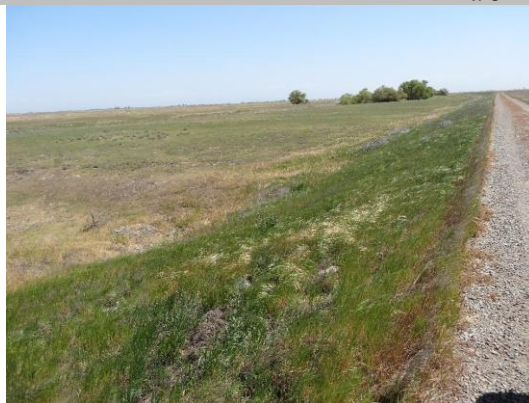
Photo 1 of 3 : UCIP\_SP\_2017\_39875\_61599.jpg

LM Start	5.26	Rating **	M	Issue No.	1231
LM End	5.26	Issue Type +	Ma	Location *	LS
Category	Supplemental			GPS Latitude/Longitude	
				Start	End
Item	DWR UCIP LMA Responsibility			37.239098 °	37.239098 °
				-120.751774 °	-120.751774 °
DWR ID					
Comment Code					
Inspector Comment					
FS_ID:39875					
DS_ID:19863					
EP_NO: N/A					
Repair Type: Non-Urgent					
Crossing Status: Found					
UCIP Comments: Clear vegetation from waterward slope and landward headwall.					
FIELD_STRUCT_DESC: 24-inch CM pipe through levee, 10.9 feet below crown. Flap gate on the waterward end. Concrete headwall on both ends. (USACE-1967). This entry matches the Drainage or Irrigation Structure referenced in O&M manual (HLM 5.34).					
FS Date: 4/18/2014

View of waterward side.

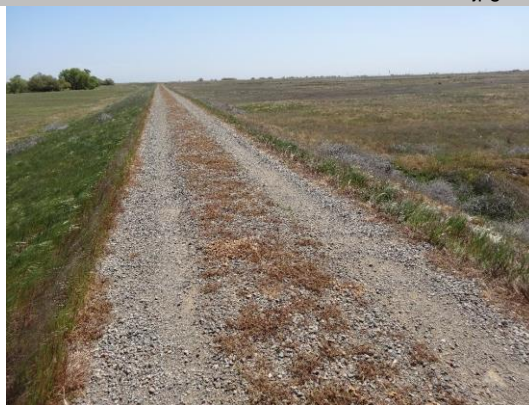
Photo 2 of 3 : UCIP\_SP\_2017\_39875\_61598.jpg

Overview of levee crown at crossing.

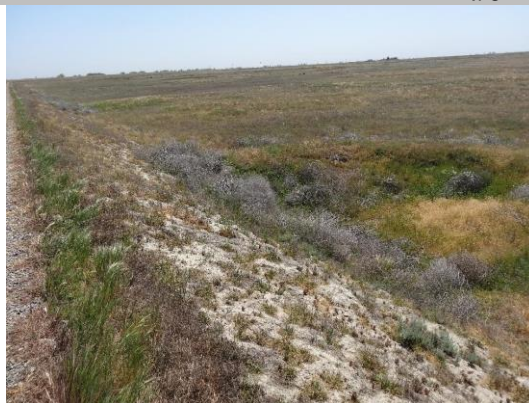
Photo 3 of 3 : UCIP\_SP\_2017\_39875\_61597.jpg

View of landward side.

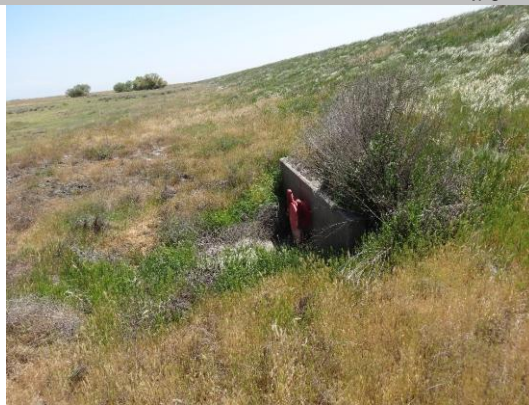
Photo 1 of 3 : UCIP\_SP\_2017\_36611\_66441.jpg

Comment Code					
Inspector Comment					
FS_ID:36611 DS_ID:19864 EP_NO: N/A Repair Type: Non-Urgent Crossing Status: Found UCIP Comments: Dense vegetation limits the inspector's visibility to identify signs of pipe failure (leaks) along the waterward slope. Recommend removing vegetation along pipe alignment to conduct proper inspection of structure. Also recommend removing excess vegetation at landward headwall. FIELD_STRUCT_DESC: 24-inch CM pipe through levee, 11.0 feet below crown. Flap gate on the waterward end. Concrete headwall on both ends. (USACE-1967). This entry matches the Drainage or Irrigation Structure referenced in O&M manual (HLM 5.63). FS Date: 4/18/2014

Concrete headwall and flap gate visible on waterward toe.

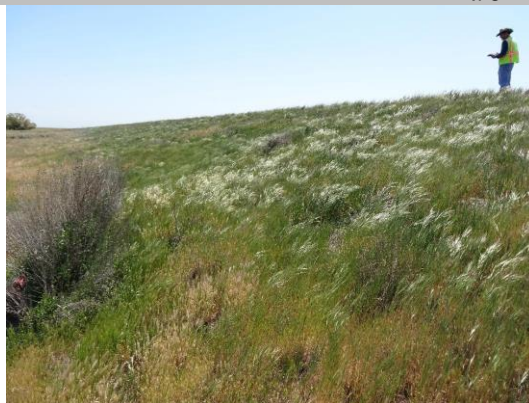
Photo 2 of 3 : UCIP\_SP\_2017\_36611\_66440.jpg

View of waterward side--dense vegetation covers slope.

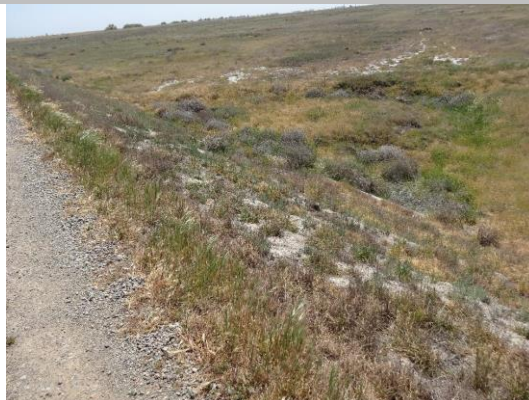
Photo 3 of 3 : UCIP\_SP\_2017\_36611\_66439.jpg

View of landward side.

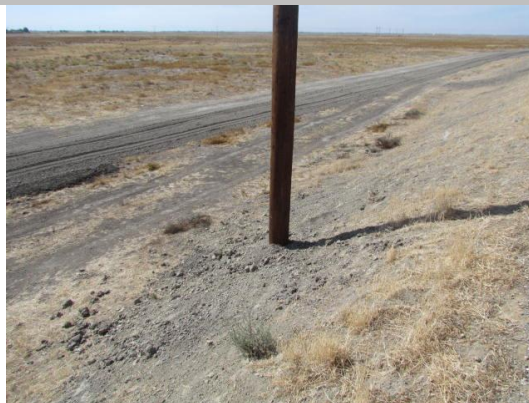
Photo 1 of 2 : SP\_2017\_NA0010\_124\_69\_20170417\_00014.jpg

LM Start	5.93	Rating **	U	Issue No.	69
LM End	6.25	Issue Type +	En	Location *	LS
Category	Earthen Levee			GPS Latitude/Longitude	
				Start	End
Item	Encroachments			37.236936 °	37.235487 °
				-120.740384 °	-120.737685 °
DWR ID	DWR_NA0010_06_f_2015_69				
Comment Code					
PO : Pole					
Inspector Comment					
Several PG& E poles within this section at the landward toe and slope.

Looking at power pole on landward slope.

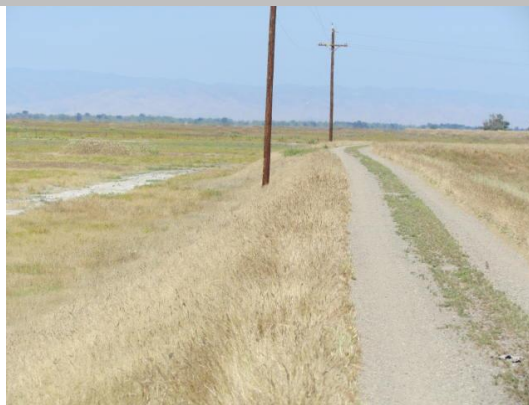
Photo 2 of 2 : SP\_2017\_NA0010\_124\_69\_20170417\_00015.jpg

Looking west at several PG&amp;E poles on landward slope.

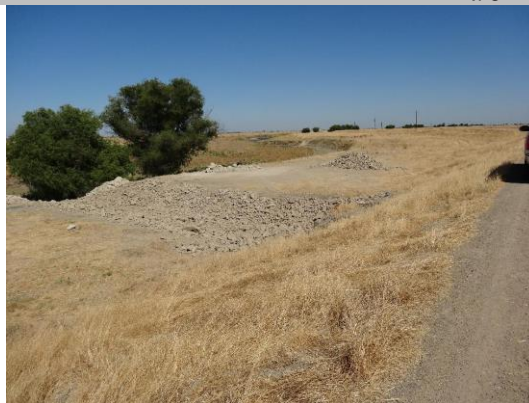
Photo 1 of 3 : UCIP\_SP\_2017\_51312\_75493.jpg

FS\_ID:51312  
DS\_ID:19865  
EP\_NO: N/A  
Repair Type: No Action Needed  
Crossing Status: Found  
UCIP Comments: 7/19/2016 Site has been repaired on WS and LS (see photos below). (DWR UCIP - omagana)5/26/2016 Erosion is undermining the WS headwall of drainage structure (photos of WS headwall provided by DWR Inspector R. Willoughby). Potential pipe failure at the outlet just behind headwall, recommend completing internal wall integrity of pipe length through levee to determine extent of damage to pipe. (DWR UCIP - omagana)4/18/2014 Need to contact owner. Sediment buildup in pipe visible on landside--recommend clearing. (DWR UCIP - omagana)  
FIELD\_STRUCT\_DESC: 24-inch corrugated metal drainage pipe through levee, 9 feet below crown. Concrete headwall on both waterside (WS) and landside (LS) ends. Flap gate on the WS end. [Additional Reference(s): DWR Levee Log, 2002. USACE San Joaquin O&M Manuals: Unit No. 601, 1967, (HLM 6.06), Unit No. 601 Part I, 1967 (Amended in 1978), Unit No. 601 Part II, 1969, and Unit No. 601 Part III, 1969].

View of WS--rock protection along drainage path.

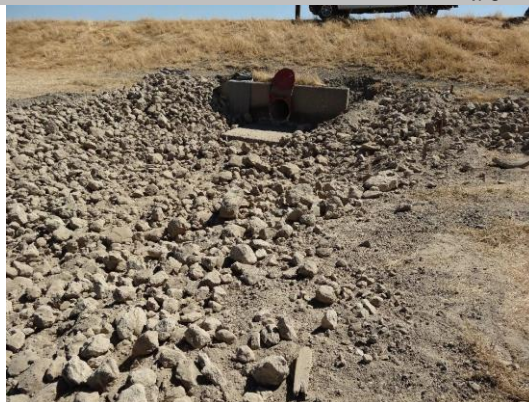
Photo 2 of 3 : UCIP\_SP\_2017\_51312\_75488.jpg

WS drainage path protected by rip rap.

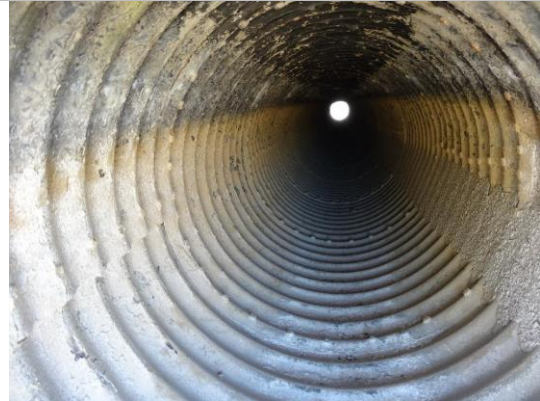
Photo 3 of 3 : UCIP\_SP\_2017\_51312\_75489.jpg

Inside view of pipe from WS.

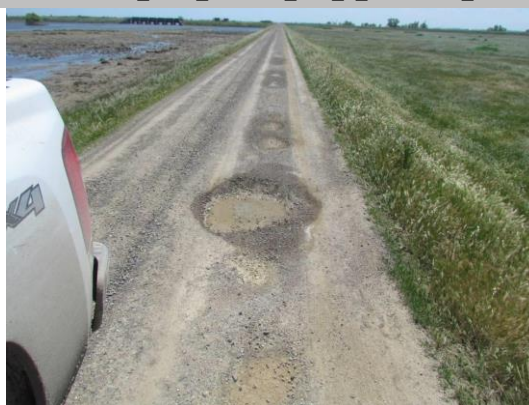
Photo 1 of 2 : SP\_2017\_NA0010\_124\_6\_20170425\_00167.jpg

LM Start	6.44	Rating **	M	Issue No.	6
LM End	11.00	Issue Type +	Ma	Location *	CR
Category	Earthen Levee			GPS Latitude/Longitude	
				Start	End
Item	Crown Surface / Depressions / Rutting			37.233587 °	37.187645 °
				-120.732480 °	-120.676996 °
DWR ID	DWR_NA0010_06_s _ 2012_6				
Comment Code					
C2 : Repair depressions or ruts in the crown or slope.					
Inspector Comment					
Levee crown should be regraded due to excessive rutting and potholes on levee crown..

Looking upstream at large pot hole on levee crown.

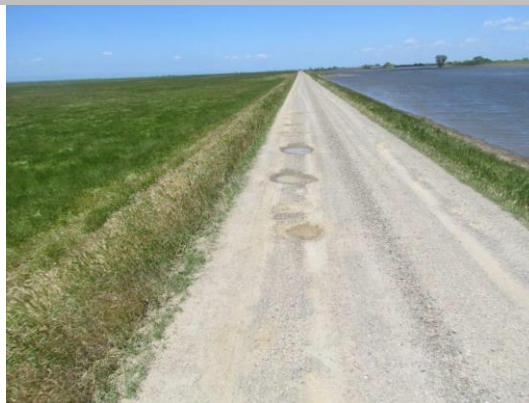
Photo 2 of 2 : SP\_2017\_NA0010\_124\_6\_20170425\_00168.jpg

LM Start	<b>6.44</b>	Rating **	M	Issue No.	<b>6 (cont)</b>
LM End	<b>11.00</b>	Issue Type +	Ma	Location *	CR

Looking downstream at typical view of rutting and pot holes on levee crown.

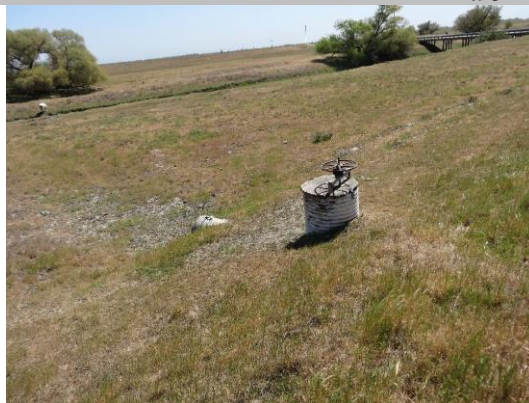
Photo 1 of 3 : UCIP\_SP\_2017\_33984\_61628.jpg

LM Start	6.70	Rating **	A/W	Issue No.	1234
LM End	6.70	Issue Type +	Ma	Location *	CR
Category	Supplemental			GPS Latitude/Longitude	
				Start	End
Item	DWR UCIP LMA Responsibility			37.230508 °	37.230508 °
				-120.729634 °	-120.729634 °
DWR ID					
Comment Code					
Inspector Comment					
FS_ID:33984					
DS_ID:19866					
EP_NO: N/A					
Repair Type: No Action Needed					
Crossing Status: Found					
UCIP Comments:					
FIELD_STRUCT_DESC: 24-inch CM pipe through levee, 7.0 feet below crown. Slide gate in 36-inch CM pipe riser in the waterward slope. Concrete headwall on the landward end. Concrete saddle and apron on the waterward end. (USACE-1967). This entry matches the Drainage or Irrigation Structure referenced in O&M manual (HLM 6.79).					
FS Date: 4/18/2014

Slide gate inside CMP riser and pipe visible on waterward side.

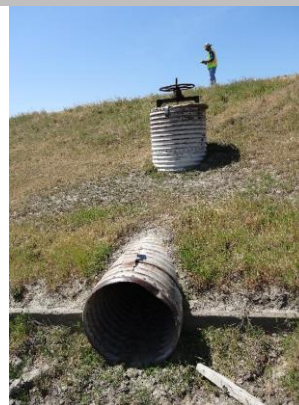
Photo 2 of 3 : UCIP\_SP\_2017\_33984\_61627.jpg

Concrete headwall visible on waterward side.

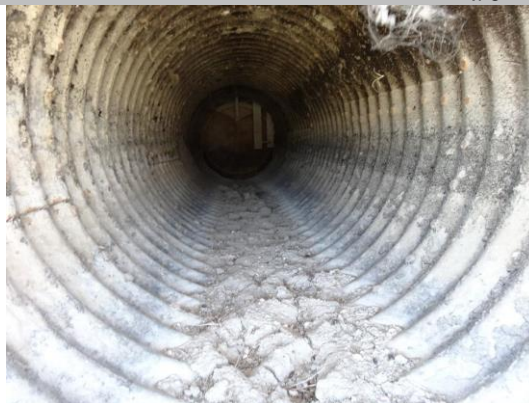
Photo 3 of 3 : UCIP\_SP\_2017\_33984\_61626.jpg

LM Start	6.70	Rating **	A/W	Issue No.	1234 (cont)	
LM End	6.70	Issue Type +	Ma	Location *	CR	
Category	Supplemental			GPS Latitude/Longitude		
				Start		End
Item	DWR UCIP LMA Responsibility			37.230508 °	37.230508 °	
				-120.729634 °	-120.729634 °	
DWR ID						
Comment Code						
Inspector Comment						
FS_ID:33984						
DS_ID:19866						
EP_NO: N/A						
Repair Type: No Action Needed						
Crossing Status: Found						
UCIP Comments:						
FIELD_STRUCT_DESC: 24-inch CM pipe through levee, 7.0 feet below crown. Slide gate in 36-inch CM pipe riser in the waterward slope. Concrete headwall on the landward end. Concrete saddle and apron on the waterward end. (USACE-1967). This entry matches the Drainage or Irrigation Structure referenced in O&M manual (HLM 6.79).						
FS Date: 4/18/2014

Inside view pipe from waterward side.

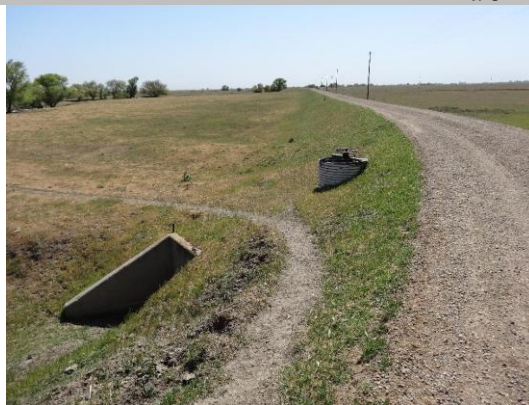
Photo 1 of 3 : UCIP\_SP\_2017\_33985\_61640.jpg

LM Start	6.89	Rating **	A/W	Issue No.	1235
LM End	6.89	Issue Type +	Ma	Location *	CR
Category	Supplemental			GPS Latitude/Longitude	
				Start	End
Item	DWR UCIP LMA Responsibility			37.228253 °	37.228253 °
				-120.727865 °	-120.727865 °
DWR ID					
Comment Code					
Inspector Comment					
FS_ID:33985 DS_ID:19867 EP_NO: N/A Repair Type: No Action Needed Crossing Status: Found UCIP Comments: FIELD_STRUCT_DESC: 36-inch CM pipe through levee, 10.7 feet below crown. Slide gate in 48-inch CM pipe riser in the waterward slope. Concrete headwall on the landward end. Concrete "U" headwall on the waterward end. (USACE-1967). This entry matches the Drainage or Irrigation Structure referenced in O&M manual (HLM 6.97). FS Date: 4/18/2014

View of waterward side.

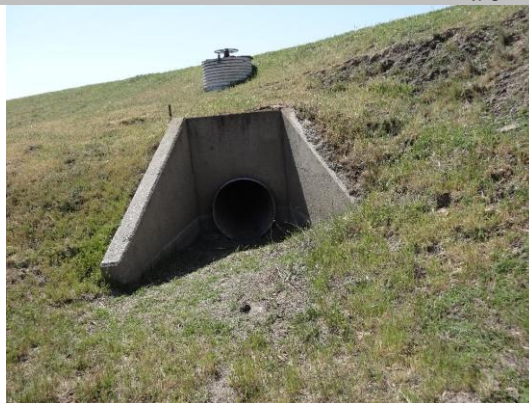
Photo 2 of 3 : UCIP\_SP\_2017\_33985\_61639.jpg

LM Start	6.89	Rating **	A/W	Issue No.	1235 (cont)
LM End	6.89	Issue Type +	Ma	Location *	CR
Category	Supplemental			GPS Latitude/Longitude	
				Start	End
Item	DWR UCIP LMA Responsibility			37.228253 °	37.228253 °
				-120.727865 °	-120.727865 °
DWR ID					
Comment Code					
Inspector Comment					
FS_ID:33985					
DS_ID:19867					
EP_NO: N/A					
Repair Type: No Action Needed					
Crossing Status: Found					
UCIP Comments:					
FIELD_STRUCT_DESC: 36-inch CM pipe through levee, 10.7 feet below crown. Slide gate in 48-inch CM pipe riser in the waterward slope. Concrete headwall on the landward end. Concrete "U" headwall on the waterward end. (USACE-1967). This entry matches the Drainage or Irrigation Structure referenced in O&M manual (HLM 6.97).					
FS Date: 4/18/2014

Concrete headwall and CMP riser visible on waterward side.

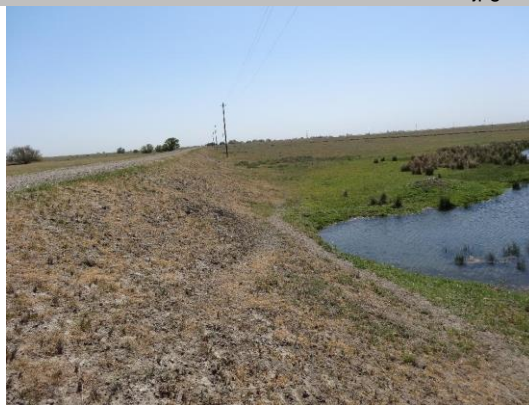
Photo 3 of 3 : UCIP\_SP\_2017\_33985\_61638.jpg

View of landward side.

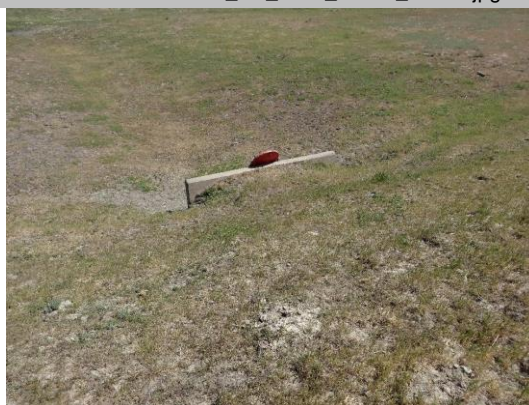
Photo 1 of 3 : UCIP\_SP\_2017\_39471\_61650.jpg

LM Start	<b>7.21</b>	Rating **	M	Issue No.	<b>1236</b>
LM End	<b>7.21</b>	Issue Type +	Ma	Location *	LS
Category	Supplemental		GPS Latitude/Longitude		
			Start	End	
Item	DWR UCIP LMA Responsibility		37.226102 °	37.226102 °	
			-120.722739 °	-120.722739 °	
DWR ID					
Comment Code					
Inspector Comment					
FS_ID:39471 DS_ID:19868 EP_NO: N/A Repair Type: Non-Urgent Crossing Status: Found UCIP Comments: Need to contact owner. Clear animal from waterward side. Some sediment buildup in pipe visible landward side--recommend clearing. FIELD_STRUCT_DESC: 24-inch CM pipe through levee, 10.6 feet below crown. Flap gate on the waterward end. Concrete headwall on both ends. (USACE-1967). This entry matches the Drainage or Irrigation Structure referenced in O&M manual (HLM 7.29). FS Date: 4/18/2014

View of waterward side.

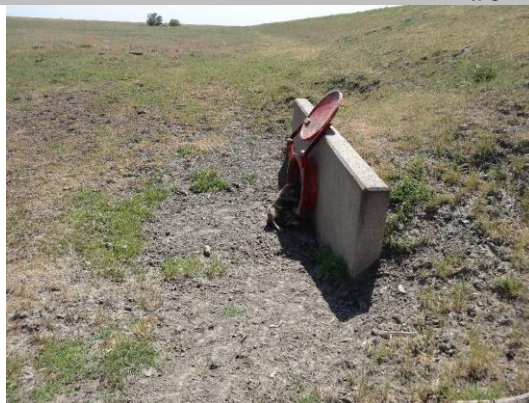
Photo 2 of 3 : UCIP\_SP\_2017\_39471\_61649.jpg

LM Start	7.21	Rating **	M	Issue No.	1236 (cont)
LM End	7.21	Issue Type +	Ma	Location *	LS
Category	Supplemental			GPS Latitude/Longitude	
				Start	End
Item	DWR UCIP LMA Responsibility			37.226102°	37.226102°
				-120.722739°	-120.722739°
DWR ID					
Comment Code					
Inspector Comment					
FS_ID:39471 DS_ID:19868 EP_NO: N/A Repair Type: Non-Urgent Crossing Status: Found UCIP Comments: Need to contact owner. Clear animal from waterward side. Some sediment buildup in pipe visible landward side--recommend clearing. FIELD_STRUCT_DESC: 24-inch CM pipe through levee, 10.6 feet below crown. Flap gate on the waterward end. Concrete headwall on both ends. (USACE-1967). This entry matches the Drainage or Irrigation Structure referenced in O&M manual (HLM 7.29). FS Date: 4/18/2014

Concrete headwall and flap gate visible on waterward side. Dead animal inside pipe.

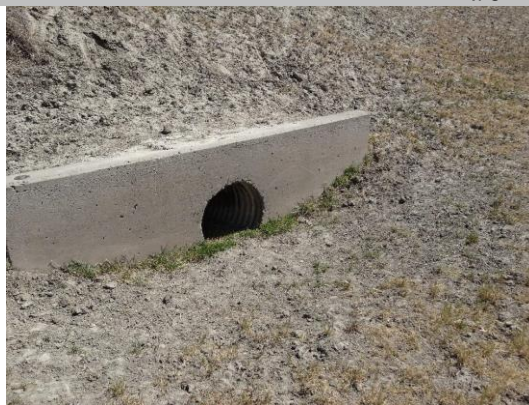
Photo 3 of 3 : UCIP\_SP\_2017\_39471\_61648.jpg

View of landward side.

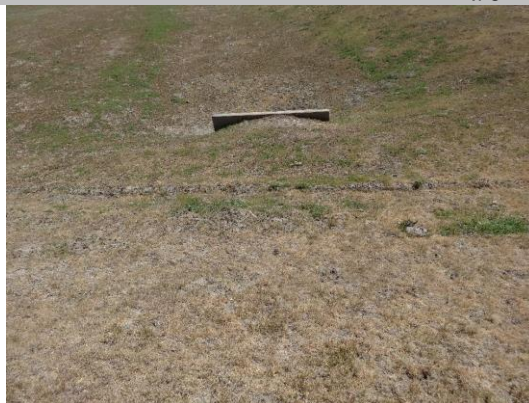
Photo 1 of 3 : UCIP\_SP\_2017\_39472\_66462.jpg

LM Start	7.66	Rating **	M	Issue No.	1237
LM End	7.66	Issue Type +	Ma	Location *	LS
Category	Supplemental			GPS Latitude/Longitude	
				Start	End
Item	DWR UCIP LMA Responsibility			37.222743 °	37.222743 °
				-120.716416 °	-120.716416 °
DWR ID					
Comment Code					
Inspector Comment					
FS_ID:39472 DS_ID:19869 EP_NO: N/A Repair Type: Non-Urgent Crossing Status: Found UCIP Comments: Some sediment buildup in pipe visible on landward side--recommend clearing. FIELD_STRUCT_DESC: 24-inch CM pipe through levee, 11.8 feet below crown. Flap gate on the waterward end. Concrete headwall on both ends. (USACE-1967). This entry matches the Drainage or Irrigation Structure referenced in O&M manual (HLM 7.74). Skewed crossing FS Date: 4/18/2014

View of waterward side.

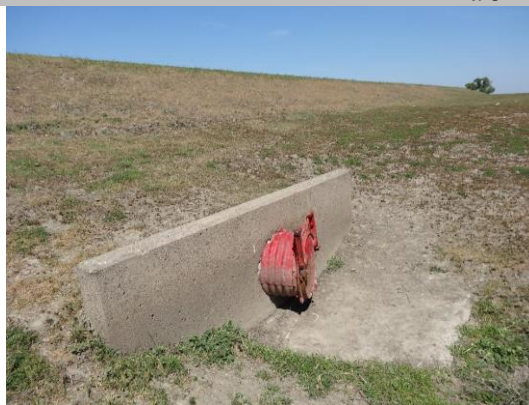
Photo 2 of 3 : UCIP\_SP\_2017\_39472\_66461.jpg

Pipe crosses levee at an angle.

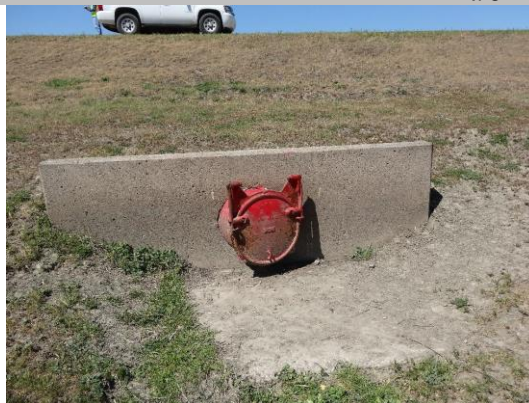
Photo 3 of 3 : UCIP\_SP\_2017\_39472\_66460.jpg

LM Start	7.66	Rating **	M	Issue No.	1237 (cont)
LM End	7.66	Issue Type +	Ma	Location *	LS
Category	Supplemental			GPS Latitude/Longitude	
				Start	End
Item	DWR UCIP LMA Responsibility			37.222743 °	37.222743 °
				-120.716416 °	-120.716416 °
DWR ID					
Comment Code					
Inspector Comment					
FS_ID:39472 DS_ID:19869 EP_NO: N/A Repair Type: Non-Urgent Crossing Status: Found UCIP Comments: Some sediment buildup in pipe visible on landward side--recommend clearing. FIELD_STRUCT_DESC: 24-inch CM pipe through levee, 11.8 feet below crown. Flap gate on the waterward end. Concrete headwall on both ends. (USACE-1967). This entry matches the Drainage or Irrigation Structure referenced in O&M manual (HLM 7.74). Skewed crossing FS Date: 4/18/2014

Concrete headwall and flap gate visible on waterward side.

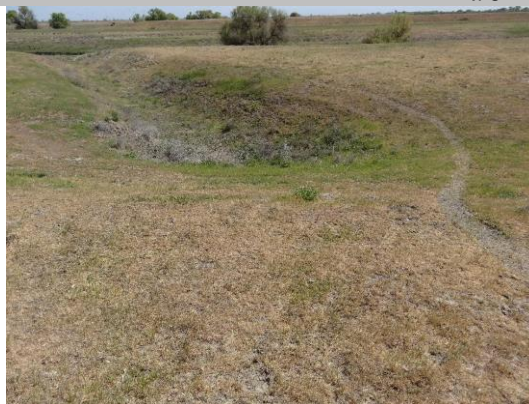
Photo 1 of 3 : UCIP\_SP\_2017\_39473\_61674.jpg

LM Start	8.13	Rating **	M	Issue No.	1238
LM End	8.13	Issue Type +	Ma	Location *	LS
Category	Supplemental			GPS Latitude/Longitude	
				Start	End
Item	DWR UCIP LMA Responsibility			37.216547 °	37.216547 °
				-120.713000 °	-120.713000 °
DWR ID					
Comment Code					
Inspector Comment					
FS_ID:39473 DS_ID:19870 EP_NO: N/A Repair Type: Non-Urgent Crossing Status: Found UCIP Comments: Sediment buildup in pipe--recommend contacting owner to clear sediment. FIELD_STRUCT_DESC: 24-inch CM pipe through levee, 16.5 feet below crown. Flap gate on the waterward end. Concrete headwall on both ends. (USACE-1967). This entry matches the Drainage or Irrigation Structure referenced in O&M manual (HLM 8.21). FS Date: 4/18/2014

View of waterward side.

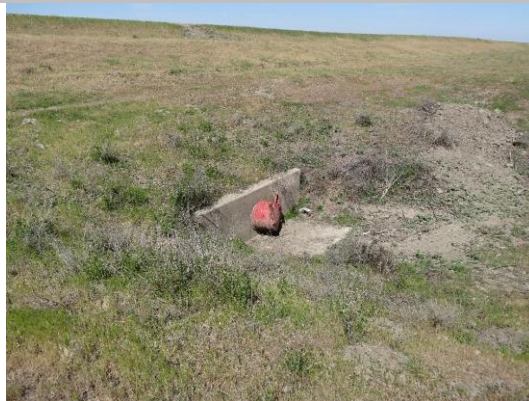
Photo 2 of 3 : UCIP\_SP\_2017\_39473\_61673.jpg

LM Start	8.13	Rating **	M	Issue No.	1238 (cont)	
LM End	8.13	Issue Type +	Ma	Location *	LS	
Category	Supplemental			GPS Latitude/Longitude		
				Start		End
Item	DWR UCIP LMA Responsibility			37.216547 °		37.216547 °
				-120.713000 °		-120.713000 °
DWR ID						
Comment Code						
Inspector Comment						
FS_ID:39473						
DS_ID:19870						
EP_NO: N/A						
Repair Type: Non-Urgent						
Crossing Status: Found						
UCIP Comments: Sediment buildup in pipe--recommend contacting owner to clear sediment.						
FIELD_STRUCT_DESC: 24-inch CM pipe through levee, 16.5 feet below crown. Flap gate on the waterward end. Concrete headwall on both ends. (USACE-1967). This entry matches the Drainage or Irrigation Structure referenced in O&M manual (HLM 8.21).						
FS Date: 4/18/2014

Pipe crosses levee at an angle.

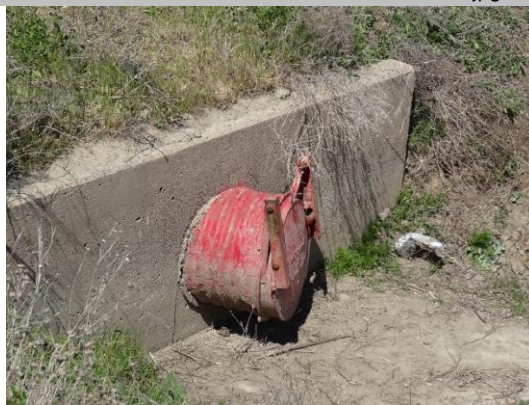
Photo 3 of 3 : UCIP\_SP\_2017\_39473\_61672.jpg

Concrete headwall and flap gate visible on waterward side.

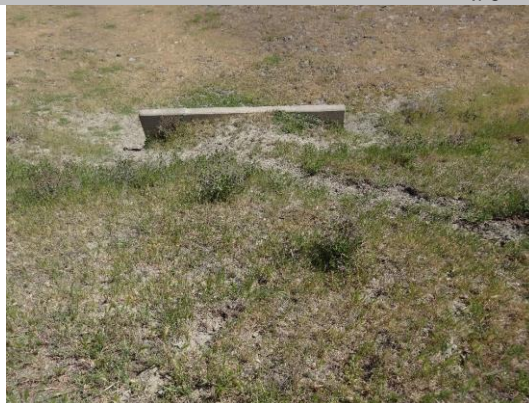
Photo 1 of 3 : UCIP\_SP\_2017\_39474\_61685.jpg

Comment Code					
Inspector Comment					
FS_ID:39474 DS_ID:19871 EP_NO: N/A Repair Type: Non-Urgent Crossing Status: Found UCIP Comments: Need to contact owner. Sediment buildup in pipe visible on landward side--recommend clearing. Good candidate for pressure test or video inspection due to signs of heavy corrosion. If no leaks after tests this crossing would be a good candidate for rehabilitation. FIELD_STRUCT_DESC: 24-inch CM pipe through levee, 9.2 feet below crown. Flap gate on the waterward end. Concrete headwall on both ends. (USACE-1967). This entry matches the Drainage or Irrigation Structure referenced in O&M manual (HLM 8.51). FS Date: 4/18/2014

View of waterward side.

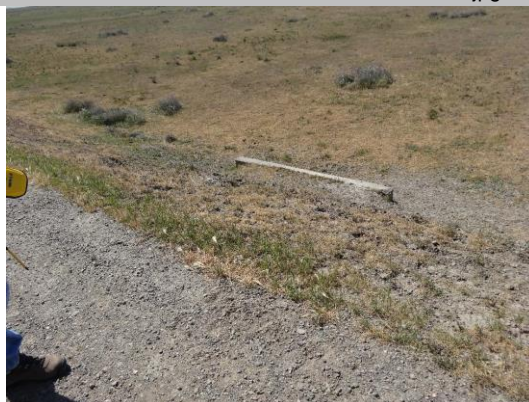
Photo 2 of 3 : UCIP\_SP\_2017\_39474\_61684.jpg

View of landward side.

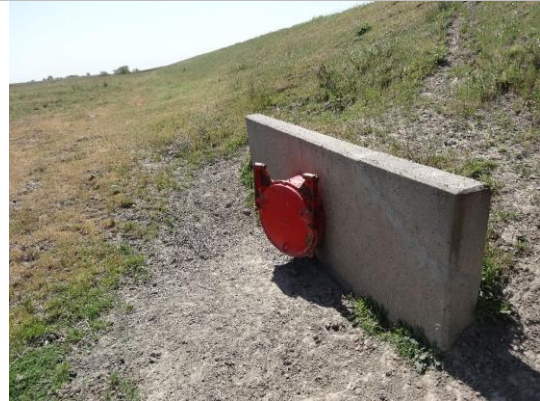
Photo 3 of 3 : UCIP\_SP\_2017\_39474\_61683.jpg

Item	DWR UCIP LMA Responsibility			37.213288 °	37.213288 °	
				-120.709503 °	-120.709503 °	
DWR ID						
Comment Code						
Inspector Comment						
FS_ID:39474						
DS_ID:19871						
EP_NO: N/A						
Repair Type: Non-Urgent						
Crossing Status: Found						
UCIP Comments: Need to contact owner. Sediment buildup in pipe visible on landward side--recommend clearing. Good candidate for pressure test or video inspection due to signs of heavy corrosion. If no leaks after tests this crossing would be a good candidate for rehabilitation.						
FIELD_STRUCT_DESC: 24-inch CM pipe through levee, 9.2 feet below crown. Flap gate on the waterward end. Concrete headwall on both ends. (USACE-1967). This entry matches the Drainage or Irrigation Structure referenced in O&M manual (HLM 8.51).						
FS Date: 4/18/2014

Pipe crosses levee at an angle.

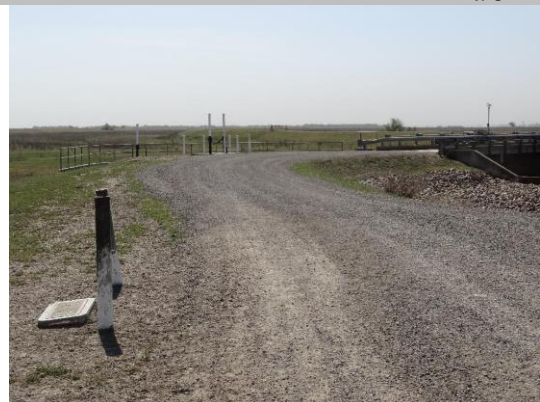
Photo 1 of 2 : UCIP\_SP\_2017\_42525\_72925.jpg

LM Start	9.52	Rating **	M	Issue No.	1240
LM End	9.52	Issue Type +	En	Location *	LS
Category	Supplemental			GPS Latitude/Longitude	
				Start	End
Item	DWR UCIP Field Study			37.202481 °	37.202481 °
				-120.695303 °	-120.695303 °
DWR ID					
Comment Code					
Inspector Comment					
FS_ID:42525 DS_ID:19872 EP_NO: N/A Repair Type: Non-Urgent Crossing Status: Indicator Found UCIP Comments: 12/5/14 Accidently missed updating record. Photos have been added and coordinates have been updated. Unable to confirm if crossing is the same cable line originally identified in desk study at levee mile 6.43. Recommend contacting owner to confirm alignment, size of conduit, and permit issued. FIELD_STRUCT_DESC: Buried telephone cable under crown of roadway. FS Date: 4/18/2014

Service box located on waterward levee shoulder.

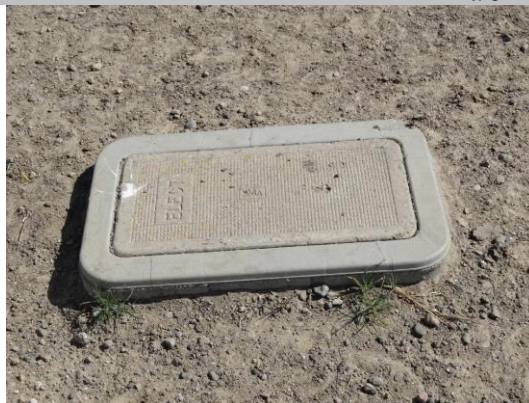
Photo 2 of 2 : UCIP\_SP\_2017\_42525\_72924.jpg

LM Start	9.52	Rating **	M	Issue No.	1240 (cont)
LM End	9.52	Issue Type +	En	Location *	LS
Category	Supplemental			GPS Latitude/Longitude	
				Start	End
Item	DWR UCIP Field Study			37.202481 °	37.202481 °
				-120.695303 °	-120.695303 °
DWR ID					
Comment Code					
Inspector Comment					
FS_ID:42525 DS_ID:19872 EP_NO: N/A Repair Type: Non-Urgent Crossing Status: Indicator Found UCIP Comments: 12/5/14 Accidently missed updating record. Photos have been added and coordinates have been updated. Unable to confirm if crossing is the same cable line originally identified in desk study at levee mile 6.43. Recommend contacting owner to confirm alignment, size of conduit, and permit issued. FIELD_STRUCT_DESC: Buried telephone cable under crown of roadway. FS Date: 4/18/2014

Service box is for electrical conduit.

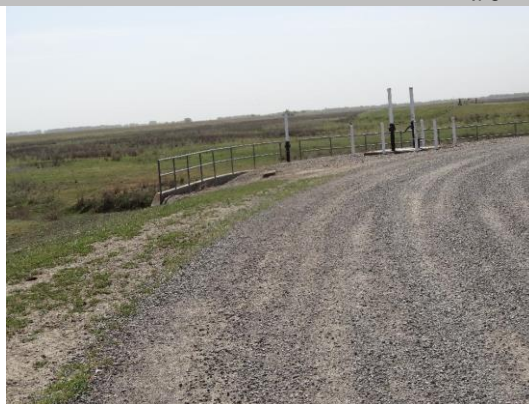
Photo 1 of 3 : UCIP\_SP\_2017\_42524\_72922.jpg

LM Start	9.56	Rating **	M	Issue No.	1241
LM End	9.56	Issue Type +	En	Location *	LS
Category	Supplemental			GPS Latitude/Longitude	
				Start	End
Item	DWR UCIP Field Study			37.202014 °	37.202014 °
				-120.694820 °	-120.694820 °
DWR ID					
Comment Code					
Inspector Comment					
FS_ID:42524 DS_ID:19873 EP_NO: N/A Repair Type: Non-Urgent Crossing Status: Found UCIP Comments: 12/5/14 Accidently missed entry. Photos have been added and coordinates have been updated by Olivia Magana. Unable to determine condition of crossing due to limited access. Recommend contacting owner to provide condition of crossing. FIELD_STRUCT_DESC: 36-inch CM pipe through levee, 14.0 feet below crown. Slide gate in concrete diversion box on the waterward shoulder. FS Date: 4/18/2014

Overview of levee crown looking upstream.

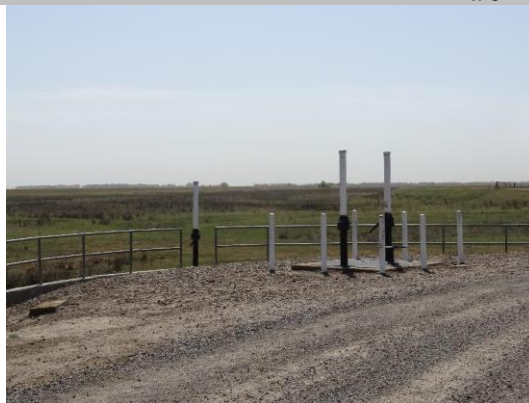
Photo 2 of 3 : UCIP\_SP\_2017\_42524\_72921.jpg

LM Start	9.56	Rating **	M	Issue No.	1241 (cont)	
LM End	9.56	Issue Type +	En	Location *	LS	
Category	Supplemental			GPS Latitude/Longitude		
				Start		End
Item	DWR UCIP Field Study			37.202014 °		37.202014 °
				-120.694820 °		-120.694820 °
DWR ID						
Comment Code						
Inspector Comment						
FS_ID:42524 DS_ID:19873 EP_NO: N/A Repair Type: Non-Urgent Crossing Status: Found UCIP Comments: 12/5/14 Accidently missed entry. Photos have been added and coordinates have been updated by Olivia Magana. Unable to determine condition of crossing due to limited access. Recommend contacting owner to provide condition of crossing. FIELD_STRUCT_DESC: 36-inch CM pipe through levee, 14.0 feet below crown. Slide gate in concrete diversion box on the waterward shoulder. FS Date: 4/18/2014

Concrete box located on waterward side.

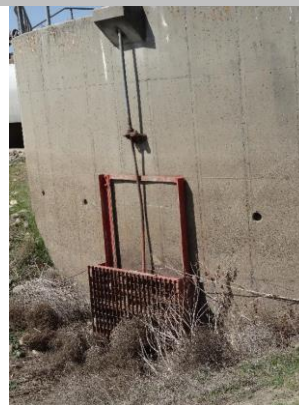
Photo 3 of 3 : UCIP\_SP\_2017\_42524\_72920.jpg

LM Start	<b>9.56</b>	Rating **	M	Issue No.	<b>1241 (cont)</b>
LM End	<b>9.56</b>	Issue Type +	En	Location *	LS

Trash gate visible on waterward side.

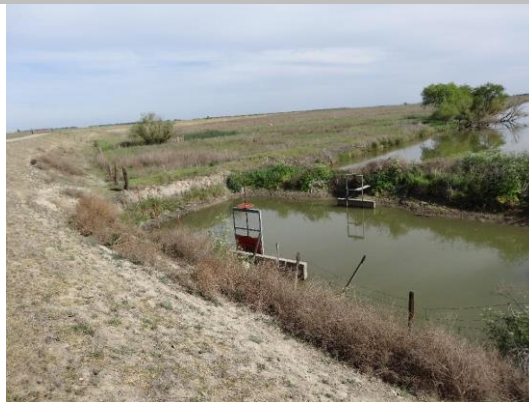
Photo 1 of 2 : UCIP\_SP\_2017\_39475\_61691.jpg

LM Start	9.66	Rating **	M	Issue No.	1247
LM End	9.66	Issue Type +	En	Location *	LS
Category	Supplemental			GPS Latitude/Longitude	
				Start	End
Item	DWR UCIP Field Study			37.200948 °	37.200948 °
				-120.694362 °	-120.694362 °
DWR ID					
Comment Code					
Inspector Comment					
FS_ID:39475					
DS_ID:19874					
EP_NO: N/A					
Repair Type: Non-Urgent					
Crossing Status: Found					
UCIP Comments: Waterward side not visible--need to determine alignment.					
FIELD_STRUCT_DESC: 36-inch CM pipe through levee, 14.0 feet below crown. Slide gate in concrete diversion box on the waterward shoulder.					
FS Date: 4/17/2014

View of landward side.

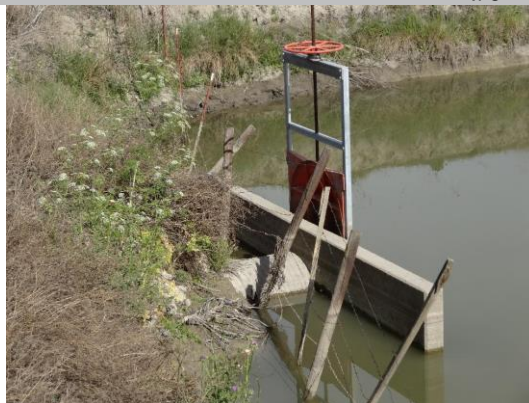
Photo 2 of 2 : UCIP\_SP\_2017\_39475\_61690.jpg

LM Start	9.66	Rating **	M	Issue No.	1247 (cont)	
LM End	9.66	Issue Type +	En	Location *	LS	
Category	Supplemental			GPS Latitude/Longitude		
				Start	End	
Item	DWR UCIP Field Study			37.200948 °	37.200948 °	
				-120.694362 °	-120.694362 °	
DWR ID						
Comment Code						
Inspector Comment						
FS_ID:39475						
DS_ID:19874						
EP_NO: N/A						
Repair Type: Non-Urgent						
Crossing Status: Found						
UCIP Comments: Waterward side not visible--need to determine alignment.						
FIELD_STRUCT_DESC: 36-inch CM pipe through levee, 14.0 feet below crown. Slide gate in concrete diversion box on the waterward shoulder.						
FS Date: 4/17/2014

Pipe, slide gate, and concrete headwall visible on landward side.

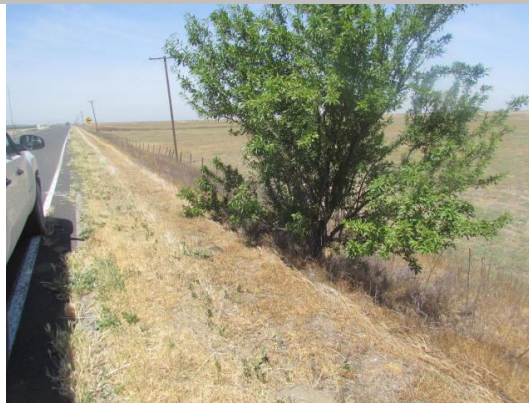
Photo 1 of 1 : SP\_2017\_NA0010\_124\_14\_20170417\_00012.jpg

LM Start	11.49	Rating **	M	Issue No.	14
LM End	11.49	Issue Type +	Ma	Location *	WS
Category	Earthen Levee			GPS Latitude/Longitude	
				Start	End
Item	Trim / Thin Trees			37.186189 °	37.186189 °
				-120.668476 °	-120.668476 °
DWR ID	DWR_NA0010_06_s_2015_14				
Comment Code					
T1 : Trim trees to at least five feet above ground level.					
Inspector Comment					
Almond tree located along Sandy Mush Rd. on waterward slope.

Looking west at tree on waterward slope.

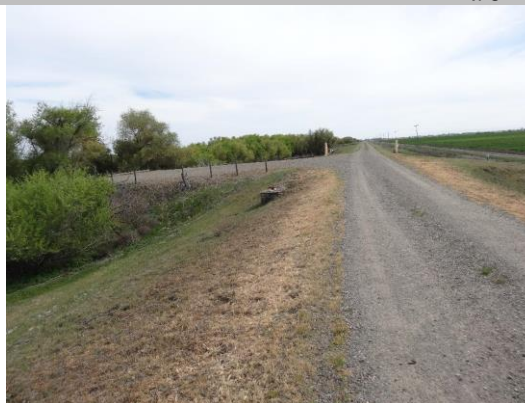
Photo 1 of 3 : UCIP\_SP\_2017\_39476\_66488.jpg

LM Start	11.74	Rating **	M	Issue No.	1249
LM End	11.74	Issue Type +	Ma	Location *	WS
Category	Supplemental			GPS Latitude/Longitude	
				Start	End
Item	DWR UCIP LMA Responsibility			37.185513 °	37.185513 °
				-120.664561 °	-120.664561 °
DWR ID					
Comment Code					
Inspector Comment					
FS_ID:39476 DS_ID:19876 EP_NO: N/A Repair Type: Non-Urgent Crossing Status: Found UCIP Comments: Clear debris from waterward and landward toes. FIELD_STRUCT_DESC: 36-inch CM pipe through levee, 17.0 feet below crown. Slide gate in pipe riser on the waterward slope. (USACE-1967). This entry matches the Drainage or Irrigation Structure referenced in O&M manual (HLM 11.82). FS Date: 4/17/2014

View of waterward side.

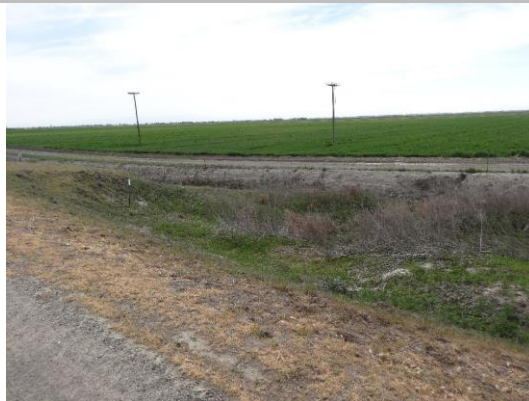
Photo 2 of 3 : UCIP\_SP\_2017\_39476\_66487.jpg

LM Start	11.74	Rating **	M	Issue No.	1249 (cont)
LM End	11.74	Issue Type +	Ma	Location *	WS
Category	Supplemental			GPS Latitude/Longitude	
				Start	End
Item	DWR UCIP LMA Responsibility			37.185513 °	37.185513 °
				-120.664561 °	-120.664561 °
DWR ID					
Comment Code					
Inspector Comment					
FS_ID:39476 DS_ID:19876 EP_NO: N/A Repair Type: Non-Urgent Crossing Status: Found UCIP Comments: Clear debris from waterward and landward toes. FIELD_STRUCT_DESC: 36-inch CM pipe through levee, 17.0 feet below crown. Slide gate in pipe riser on the waterward slope. (USACE-1967). This entry matches the Drainage or Irrigation Structure referenced in O&M manual (HLM 11.82). FS Date: 4/17/2014

View of landward side.

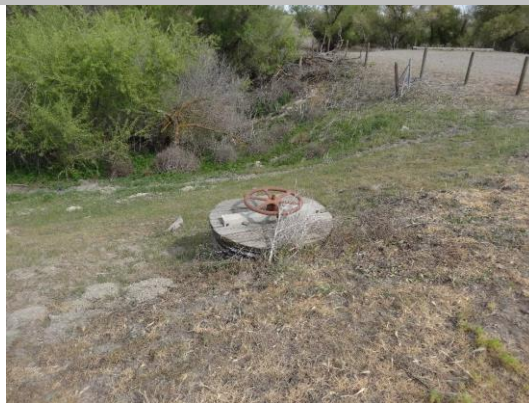
Photo 3 of 3 : UCIP\_SP\_2017\_39476\_66486.jpg

LM Start	11.74	Rating **	M	Issue No.	1249 (cont)
LM End	11.74	Issue Type +	Ma	Location *	WS

Slide gate inside CMP riser located on waterward slope.

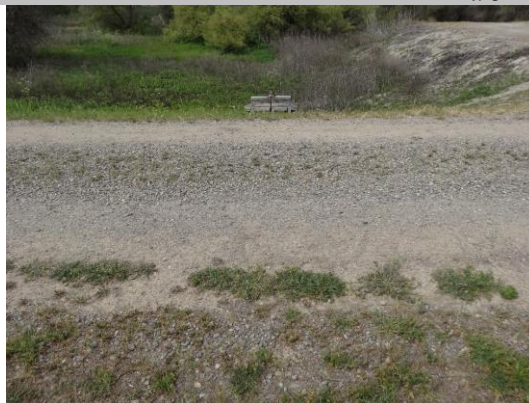
Photo 1 of 3 : UCIP\_SP\_2017\_39477\_66492.jpg

LM Start	13.22	Rating **	M	Issue No.	1250
LM End	13.22	Issue Type +	Ma	Location *	WS
Category	Supplemental			GPS Latitude/Longitude	
				Start	End
Item	DWR UCIP LMA Responsibility			37.171675 °	37.171675 °
				-120.655064 °	-120.655064 °
DWR ID					
Comment Code					
Inspector Comment					
FS_ID:39477					
DS_ID:19877					
EP_NO: N/A					
Repair Type: Non-Urgent					
Crossing Status: Found					
UCIP Comments: Not accessible--crossing is buried on landward side.					
Need to contact owner to determine status.					
FIELD_STRUCT_DESC: 24-inch CM pipe through levee, 10.8 feet below crown. Flap gate on the waterward end. (USACE-1967). This entry matches the Drainage or Irrigation Structure referenced in O&M manual (HLM 13.30).					
FS Date: 4/17/2014

View of levee crown at crossing.
