**Flood Control Project Maintenance  
Levee Inspections**  
**LMA District Cover Sheet**  
**Spring 2017 Levee Inspection Results**

**Lower San Joaquin Levee District**

Waterway			Bank	Unit Miles
Unit No. 01 San Joaquin River			Right	22.52
	Spring (March - May)	Summer (June - August)	(September - November) Fall	Winter (December - February)
Unit Maintenance Rating (Fall Only)				
Date of Inspection	4/17/2017 - 4/20/2017			
DWR Inspector	Richard Willoughby			
Accompanied By

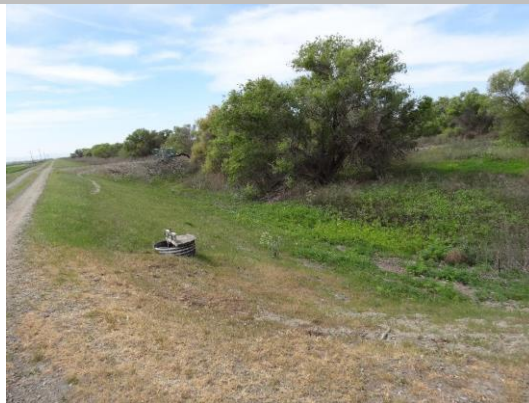
Photo 2 of 3 : UCIP\_SP\_2017\_39477\_66494.jpg

LM Start	13.22	Rating **	M	Issue No.	1250 (cont)
LM End	13.22	Issue Type +	Ma	Location *	WS

View of waterward slope.

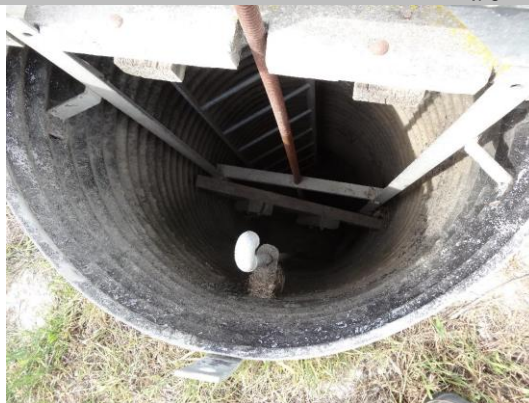
Photo 3 of 3 : UCIP\_SP\_2017\_39477\_66495.jpg

LM Start	13.22	Rating **	M	Issue No.	1250 (cont)
LM End	13.22	Issue Type +	Ma	Location *	WS
Category	Supplemental			GPS Latitude/Longitude	
				Start	End
Item	DWR UCIP LMA Responsibility			37.171675 °	37.171675 °
				-120.655064 °	-120.655064 °
DWR ID					
Comment Code					
Inspector Comment					
FS_ID:39477					
DS_ID:19877					
EP_NO: N/A					
Repair Type: Non-Urgent					
Crossing Status: Found					
UCIP Comments: Not accessible--crossing is buried on landward side.					
Need to contact owner to determine status.					
FIELD_STRUCT_DESC: 24-inch CM pipe through levee, 10.8 feet below crown. Flap gate on the waterward end. (USACE-1967). This entry matches the Drainage or Irrigation Structure referenced in O&M manual (HLM 13.30).					
FS Date: 4/17/2014

Inside view of CMP riser located on waterward slope.

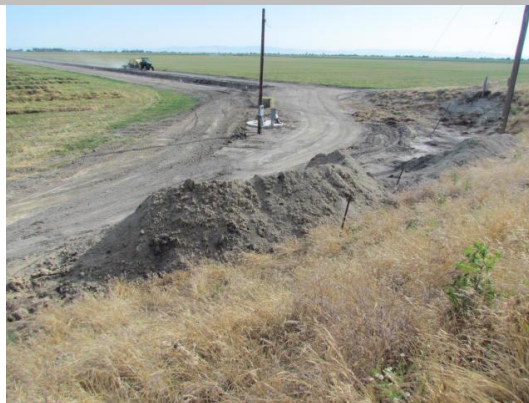
Photo 1 of 1 : SP\_2017\_NA0010\_124\_68\_20170417\_00013.jpg

LM Start	13.24	Rating **	M	Issue No.	68
LM End	13.24	Issue Type +	En	Location *	LS
Category	Earthen Levee			GPS Latitude/Longitude	
				Start	End
Item	Encroachments			37.171686 °	37.171686 °
				-120.654562 °	-120.654562 °
DWR ID	DWR_NA0010_06_f_2015_68				
Comment Code					
MA : Material					
Inspector Comment					
Landowner stockpile dirt at landward toe.

Looking west at dirt stockpile at landward toe.

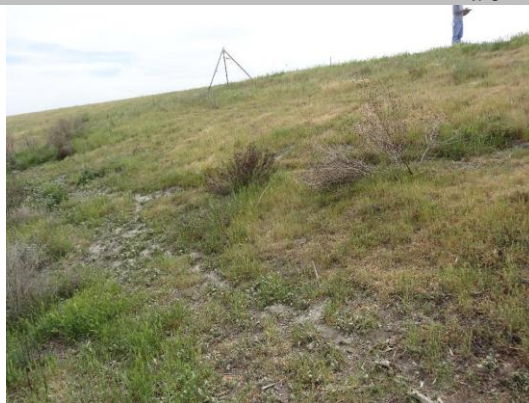
Photo 1 of 3 : UCIP\_SP\_2017\_39478\_66496.jpg

LM Start	14.36	Rating **	M	Issue No.	1251
LM End	14.36	Issue Type +	Ma	Location *	LS
Category	Supplemental			GPS Latitude/Longitude	
				Start	End
Item	DWR UCIP LMA Responsibility			37.167888 °	37.167888 °
				-120.636419 °	-120.636419 °
DWR ID					
Comment Code					
Inspector Comment					
FS_ID:39478 DS_ID:19878 EP_NO: N/A Repair Type: Non-Urgent Crossing Status: Found UCIP Comments: Not accessible--crossing is buried on landward side. Need to contact owner to determine status. FIELD_STRUCT_DESC: 24-inch CM pipe through levee, 12.3 feet below crown. Flap gate on the waterward end. (USACE-1967). This entry matches the Drainage or Irrigation Structure referenced in O&M manual (HLM 14.44). FS Date: 4/17/2014

View of waterward slope.

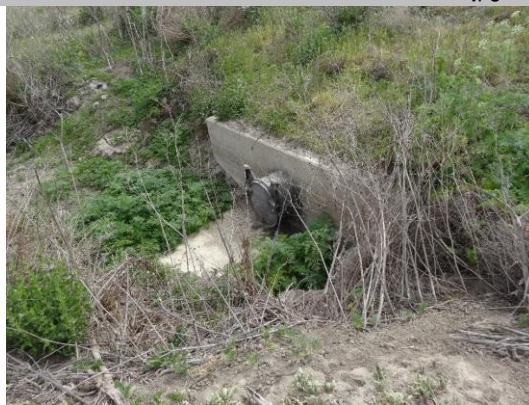
Photo 2 of 3 : UCIP\_SP\_2017\_39478\_66497.jpg

LM Start	<b>14.36</b>	Rating **	M	Issue No.	<b>1251 (cont)</b>
LM End	<b>14.36</b>	Issue Type +	Ma	Location *	LS

View of pipe daylight, flap gate, and concrete headwall visible on waterward toe.

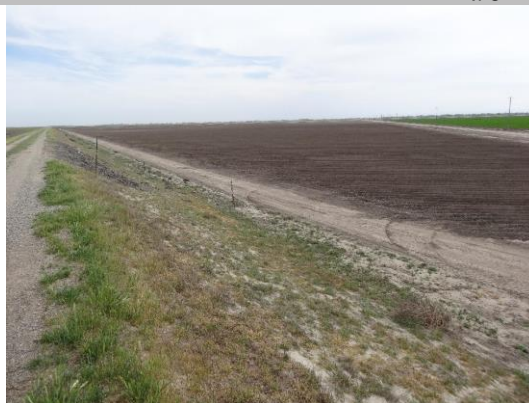
Photo 3 of 3 : UCIP\_SP\_2017\_39478\_66498.jpg

LM Start	14.36	Rating **	M	Issue No.	1251 (cont)
LM End	14.36	Issue Type +	Ma	Location *	LS
Category	Supplemental			GPS Latitude/Longitude	
				Start	End
Item	DWR UCIP LMA Responsibility			37.167888 °	37.167888 °
				-120.636419 °	-120.636419 °
DWR ID					
Comment Code					
Inspector Comment					
FS_ID:39478					
DS_ID:19878					
EP_NO: N/A					
Repair Type: Non-Urgent					
Crossing Status: Found					
UCIP Comments: Not accessible--crossing is buried on landward side.					
Need to contact owner to determine status.					
FIELD_STRUCT_DESC: 24-inch CM pipe through levee, 12.3 feet below crown. Flap gate on the waterward end. (USACE-1967). This entry matches the Drainage or Irrigation Structure referenced in O&M manual (HLM 14.44).					
FS Date: 4/17/2014

View of landward slope.

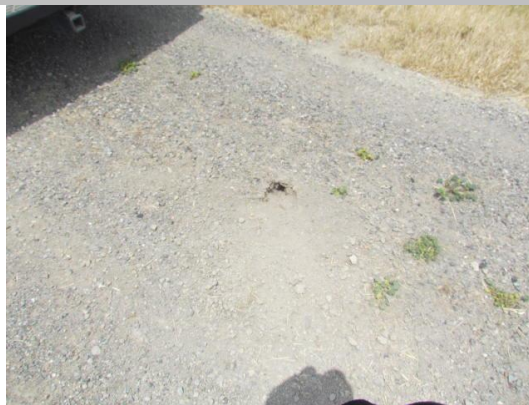
Photo 1 of 1 : SP\_2017\_NA0010\_124\_1212\_20170417\_00034.jpg

LM Start	14.94	Rating **	M	Issue No.	1212
LM End	14.94	Issue Type +	Ma	Location *	CR
Category	Earthen Levee			GPS Latitude/Longitude	
				Start	End
Item	Animal Control			37.162287 °	37.162287 °
				-120.628791 °	-120.628791 °
DWR ID	DWR_NA0010_06_s _ 2015_1212				
Comment Code					
A3 : No rodents visible, but rodent burrows visible; need to backfill and compact or grout burrows.					
Inspector Comment					
Several rodent holes noted on levee crown and landside and waterside slopes.

Looking at rodent hole on levee crown.

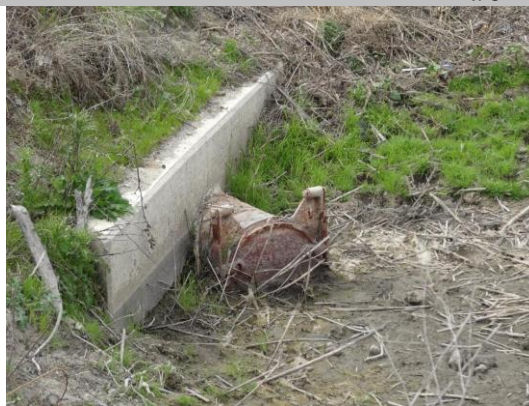
Photo 1 of 3 : UCIP\_SP\_2017\_39480\_66507.jpg

LM Start	15.68	Rating **	M	Issue No.	1252
LM End	15.68	Issue Type +	Ma	Location *	LS
Category	Supplemental			GPS Latitude/Longitude	
				Start	End
Item	DWR UCIP LMA Responsibility			37.156934 °	37.156934 °
				-120.617210 °	-120.617210 °
DWR ID					
Comment Code					
Inspector Comment					
FS_ID:39480 DS_ID:19884 EP_NO: N/A Repair Type: Non-Urgent Crossing Status: Found UCIP Comments: Need to contact owner. Sediment buildup on both the waterward and landward side. Recommend removing sediment buildup from both side. Also recommend clearing excess sediment inside crossing. FIELD_STRUCT_DESC: 24-inch CM pipe through levee, 14.0 feet below crown. Flap gate on the waterward end. (USACE-1967). This entry matches the Drainage or Irrigation Structure referenced in O&M manual (HLM 15.76). FS Date: 4/17/2014

Flap gate buried halfway on waterward side.

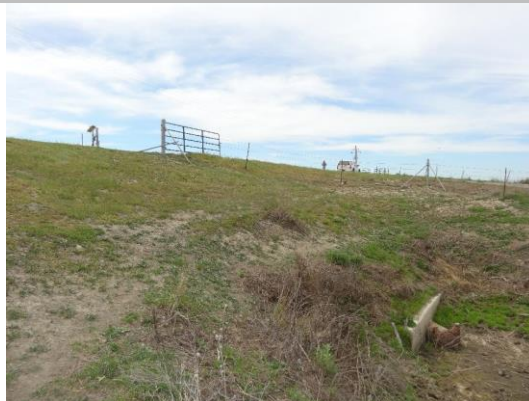
Photo 2 of 3 : UCIP\_SP\_2017\_39480\_66506.jpg

LM Start	15.68	Rating **	M	Issue No.	1252 (cont)	
LM End	15.68	Issue Type +	Ma	Location *	LS	
Category	Supplemental			GPS Latitude/Longitude		
				Start		End
Item	DWR UCIP LMA Responsibility			37.156934 °	37.156934 °	
				-120.617210 °	-120.617210 °	
DWR ID						
Comment Code						
Inspector Comment						
FS_ID:39480 DS_ID:19884 EP_NO: N/A Repair Type: Non-Urgent Crossing Status: Found UCIP Comments: Need to contact owner. Sediment buildup on both the waterward and landward side. Recommend removing sediment buildup from both side. Also recommend clearing excess sediment inside crossing. FIELD_STRUCT_DESC: 24-inch CM pipe through levee, 14.0 feet below crown. Flap gate on the waterward end. (USACE-1967). This entry matches the Drainage or Irrigation Structure referenced in O&M manual (HLM 15.76). FS Date: 4/17/2014

View of waterward side.

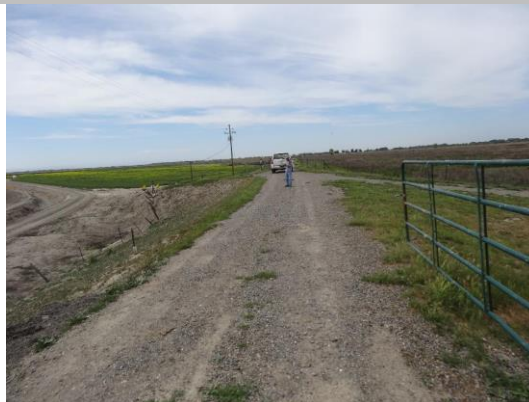
Photo 3 of 3 : UCIP\_SP\_2017\_39480\_66505.jpg

LM Start	<b>15.68</b>	Rating **	M	Issue No.	<b>1252 (cont)</b>
LM End	<b>15.68</b>	Issue Type +	Ma	Location *	LS

Overview of levee crown at crossing.

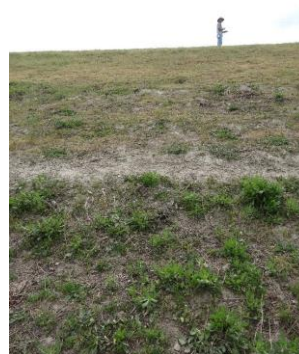
Photo 1 of 3 : UCIP\_SP\_2017\_36663\_66530.jpg

LM Start	15.82	Rating **	M	Issue No.	1253
LM End	15.82	Issue Type +	Ma	Location *	LS
Category	Supplemental			GPS Latitude/Longitude	
				Start	End
Item	DWR UCIP LMA Responsibility			37.155539 °	37.155539 °
				-120.615303 °	-120.615303 °
DWR ID					
Comment Code					
Inspector Comment					
FS_ID:36663 DS_ID:19885 EP_NO: N/A Repair Type: Non-Urgent Crossing Status: Found UCIP Comments: Need to contact owner to determine status of crossing. Waterward side is buried and not accessible. Landward side headwall is blocked by dense vegetation. Recommend confirming status of flap gate on waterward side and removing dense vegetation form landward side. FIELD_STRUCT_DESC: 36-inch CM pipe through levee, 16.6 feet below crown. Flap gate on the waterward end. (USACE-1967). This entry matches the Drainage or Irrigation Structure referenced in O&M manual (HLM 15.91). FS Date: 4/17/2014

View of waterward side, Photo 1 of 3.

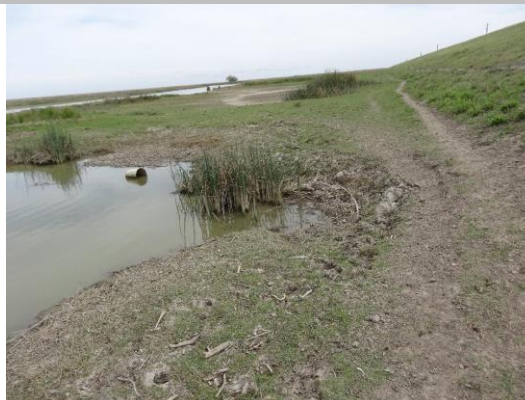
Photo 2 of 3 : UCIP\_SP\_2017\_36663\_66526.jpg

View of waterward side, photo 2 of 3.

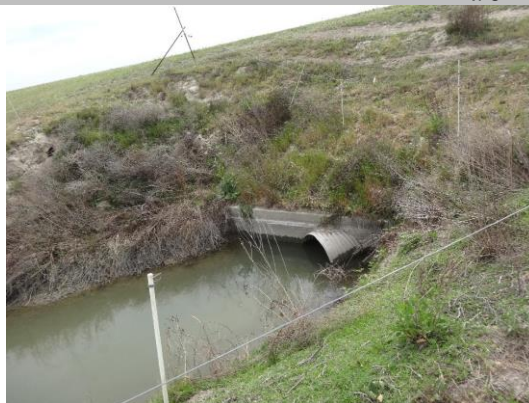
Photo 2 of 3 : UCIP\_SP\_2017\_36665\_66539.jpg

LM Start	16.40	Rating **	M	Issue No.	1254 (cont)	
LM End	16.40	Issue Type +	En	Location *	LS	
Category	Supplemental			GPS Latitude/Longitude		
				Start		End
Item	DWR UCIP Field Study			37.149747 °		37.149747 °
				-120.607702 °		-120.607702 °
DWR ID						
Comment Code						
Inspector Comment						
FS_ID:36665						
DS_ID:19559						
EP_NO: N/A						
Repair Type: Non-Urgent						
Crossing Status: Found						
UCIP Comments: Need to contact owner to determine status of crossing. Unable to confirm pipe diameter.						
FIELD_STRUCT_DESC: 36-inch CM pipe through the levee, 5.9 feet below the crown. Slide gate on the waterward side. Siphon extends under channel. (USACE-1967). This entry matches the Drainage or Irrigation Structure referenced in O&M manual (HLM 16.49).						
FS Date: 4/17/2014

Concrete headwall and pipe visible on waterward side.

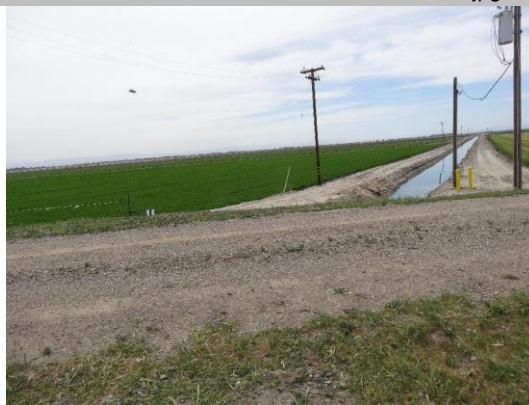
Photo 3 of 3 : UCIP\_SP\_2017\_36665\_66540.jpg

View of landward side, photo 1 of 2.

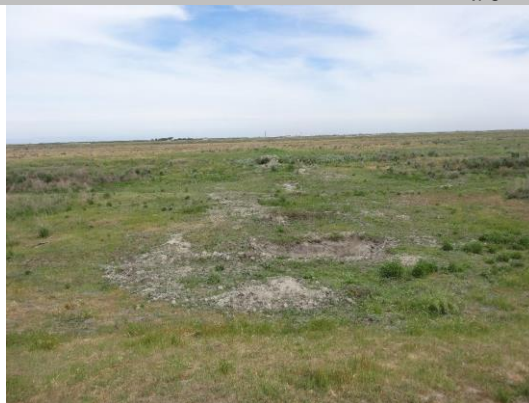
Photo 2 of 3 : UCIP\_SP\_2017\_49974\_66564.jpg

Item	DWR UCIP Field Study			37.119268 °	37.119268 °	
				-120.587208 °	-120.587208 °	
DWR ID						
Comment Code						
Inspector Comment						
FS_ID:49974 DS_ID:19888 EP_NO: 3040 Repair Type: Urgent Crossing Status: Found UCIP Comments: 7/20/2016 Same as previous inspection. Dense vegetation prevents proper inspection along floodway. (DWR UCIP - omagana)4/17/2014 Need to contact owner. Leak on waterward toe approximately 15 feet from toe. Good candidate for video or pressure test. (DWR UCIP - omagana) FIELD_STRUCT_DESC: 48-inch corrugated metal irrigation pipe through levee, 8.8 feet below crown. Slide gate in riser pipe is located on the landside (LS) (not waterside (WS) slope). Concrete headwall on is located on the LS (not WS). Siphon under channel. 24-inch corrugated metal pipe (CMP) "clean out" point at the center of channel with metal plate cover. (Permit No. 3040, 1960 - Newhall Land and Farming Company) [Additional Reference(s): DWR Levee Log, 2002] FS Date: 7/20/2016

Overview of Eastside Bypass.

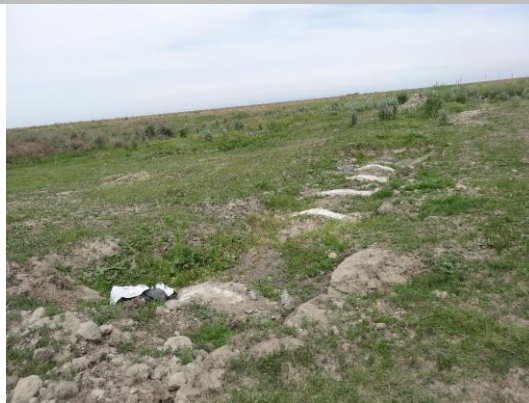
Photo 3 of 3 : UCIP\_SP\_2017\_49974\_66563.jpg

Channel sections have been excavated across Eastside Bypass.

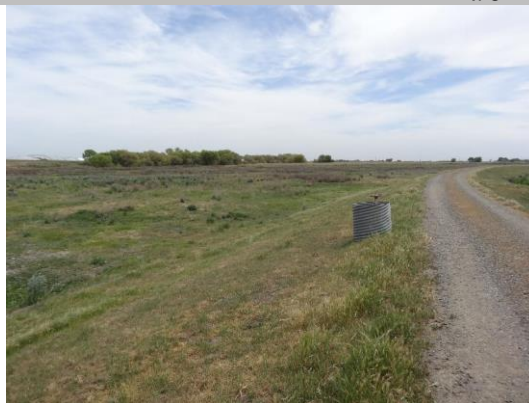
Photo 1 of 3 : UCIP\_SP\_2017\_36687\_66579.jpg

LM Start	18.89	Rating **	M	Issue No.	1257
LM End	18.89	Issue Type +	Ma	Location *	LS
Category	Supplemental			GPS Latitude/Longitude	
				Start	End
Item	DWR UCIP LMA Responsibility			37.118178 °	37.118178 °
				-120.586783 °	-120.586783 °
DWR ID					
Comment Code					
Inspector Comment					
FS_ID:36687 DS_ID:19889 EP_NO: N/A Repair Type: Non-Urgent Crossing Status: Found UCIP Comments: Dense vegetation limits the inspector's visibility to identify signs of pipe failure (leaks) along the landward slope. Recommend removing vegetation along pipe alignment to conduct proper inspection of structure. FIELD_STRUCT_DESC: 24-inch CM pipe through levee, 10.2 feet below crown. Slide gate in pipe riser on the waterward slope. (USACE-1967). This entry matches the Drainage or Irrigation Structure referenced in O&M manual (HLM 18.97). FS Date: 4/17/2014

View of waterward side.

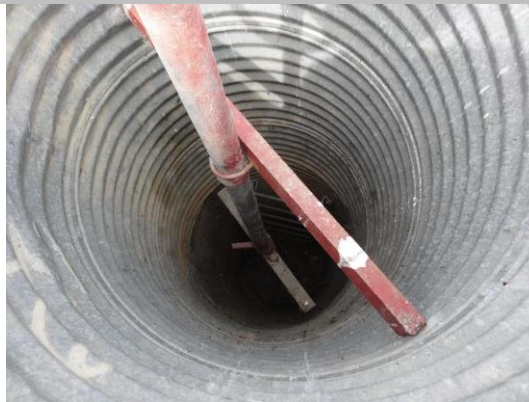
Photo 2 of 3 : UCIP\_SP\_2017\_36687\_66582.jpg

Inside view of CMP riser located on waterward slope.

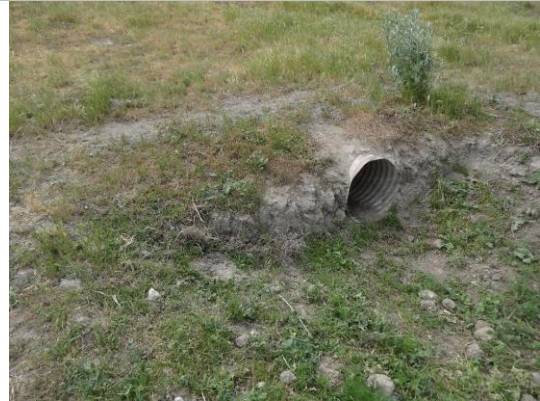
Photo 3 of 3 : UCIP\_SP\_2017\_36687\_66581.jpg

Comment Code					
Inspector Comment					
FS_ID:36687					
DS_ID:19889					
EP_NO: N/A					
Repair Type: Non-Urgent					
Crossing Status: Found					
UCIP Comments: Dense vegetation limits the inspector's visibility to identify signs of pipe failure (leaks) along the landward slope.					
Recommend removing vegetation along pipe alignment to conduct proper inspection of structure.					
FIELD_STRUCT_DESC: 24-inch CM pipe through levee, 10.2 feet below crown. Slide gate in pipe riser on the waterward slope. (USACE-1967). This entry matches the Drainage or Irrigation Structure referenced in O&M manual (HLM 18.97).					
FS Date: 4/17/2014

Pipe daylight on waterward side.

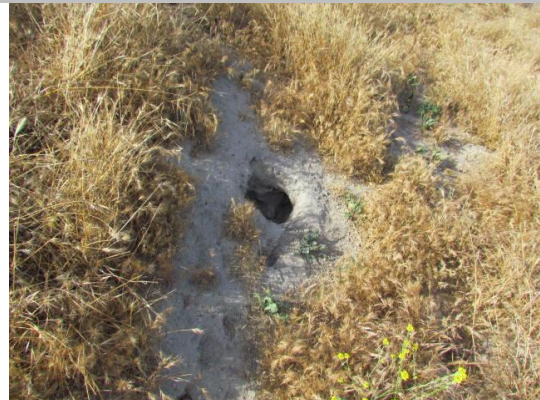
Photo 1 of 5 : SP\_2017\_NA0010\_124\_1211\_20170417\_00029.jpg

LM Start	19.14	Rating **	U	Issue No.	1211
LM End	19.14	Issue Type +	Ma	Location *	WS
Category	Earthen Levee			GPS Latitude/Longitude	
				Start	End
Item	Animal Control			37.114793 °	37.114793 °
				-120.587582 °	-120.587582 °
DWR ID	DWR_NA0010_06_s_2015_1211				
Comment Code					
A1 : Exterminate rodents and backfill and compact or grout burrows.					
Inspector Comment					
Several large rodent holes with more than 2 cubic feet of material was noted on waterward slope

Looking at rodent hole on waterward slope. Spring 2016

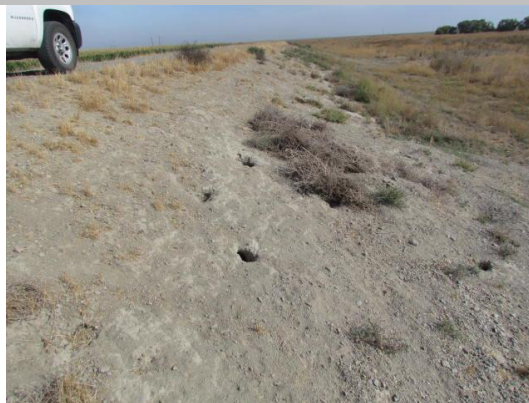
Photo 2 of 5 : SP\_2017\_NA0010\_124\_1211\_20170417\_00030.jpg

Looking at several rodent holes on waterward slope. (Fall 2015)

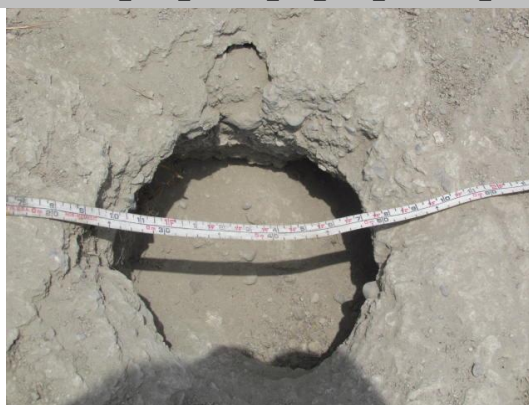
Photo 3 of 5 : SP\_2017\_NA0010\_124\_1211\_20170417\_00031.jpg

Looking at close-up view of large rodent hole on waterward slope. (Spring 2015)

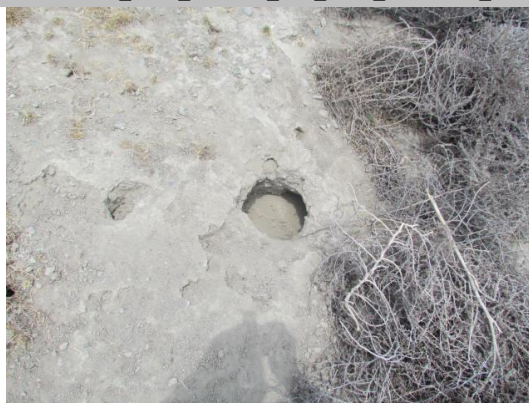
Photo 4 of 5 : SP\_2017\_NA0010\_124\_1211\_20170417\_00032.jpg

Looking at large rodent hole on waterward slope. Spring 2015

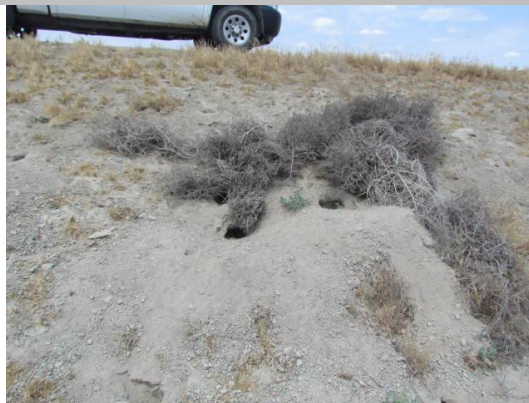
Photo 5 of 5 : SP\_2017\_NA0010\_124\_1211\_20170417\_00033.jpg

LM Start	19.14	Rating **	U	Issue No.	1211 (cont)
LM End	19.14	Issue Type +	Ma	Location *	WS
Category	Earthen Levee			GPS Latitude/Longitude	
				Start	End
Item	Animal Control			37.114793 °	37.114793 °
				-120.587582 °	-120.587582 °
DWR ID	DWR_NA0010_06_s_2015_1211				
Comment Code					
A1 : Exterminate rodents and backfill and compact or grout burrows.					
Inspector Comment					
Several large rodent holes with more than 2 cubic feet of material was noted on waterward slope

Looking west at several rodent holes on waterward slope. Spring 2015

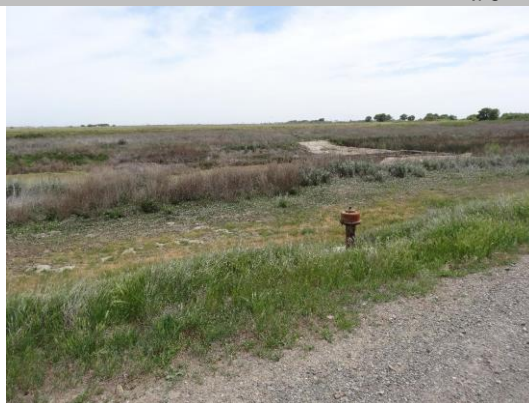
Photo 1 of 3 : UCIP\_SP\_2017\_36688\_66583.jpg

LM Start	19.28	Rating **	M	Issue No.	1258
LM End	19.28	Issue Type +	Ma	Location *	WS
Category	Supplemental			GPS Latitude/Longitude	
				Start	End
Item	DWR UCIP LMA Responsibility			37.112902 °	37.112902 °
				-120.588751 °	-120.588751 °
DWR ID					
Comment Code					
Inspector Comment					
FS_ID:36688 DS_ID:19890 EP_NO: N/A Repair Type: Non-Urgent Crossing Status: Found UCIP Comments: Dense vegetation limits the inspector's visibility to identify signs of pipe failure (leaks) along the slopes. Recommend removing vegetation along pipe alignment to conduct proper inspection of structure. FIELD_STRUCT_DESC: 48-inch CM pipe through levee, 20.0 feet below crown. Slide gate in pipe riser on the waterward slope. (USACE-1967). This entry matches the Drainage or Irrigation Structure referenced in O&M manual (HLM 19.36). Rip rap along landward slope. FS Date: 4/17/2014

View of waterward side.

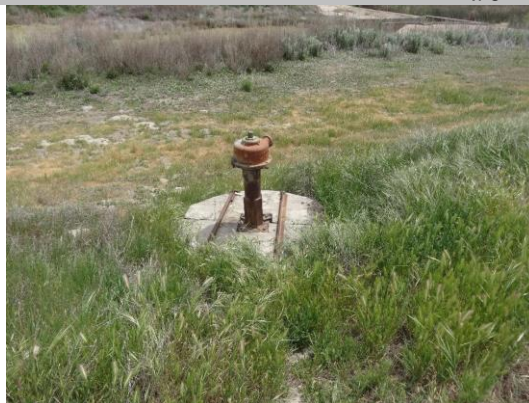
Photo 2 of 3 : UCIP\_SP\_2017\_36688\_66584.jpg

Riser located on waterward slope.

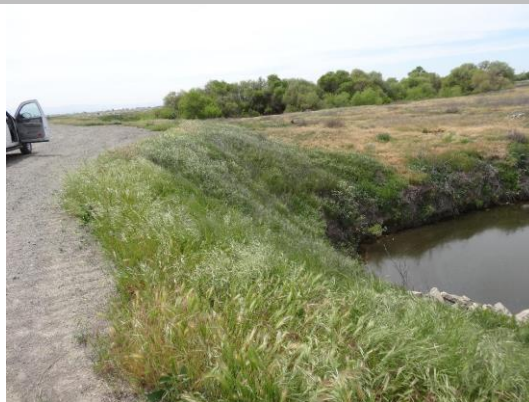
Photo 3 of 3 : UCIP\_SP\_2017\_36688\_66586.jpg

View of landward slope.

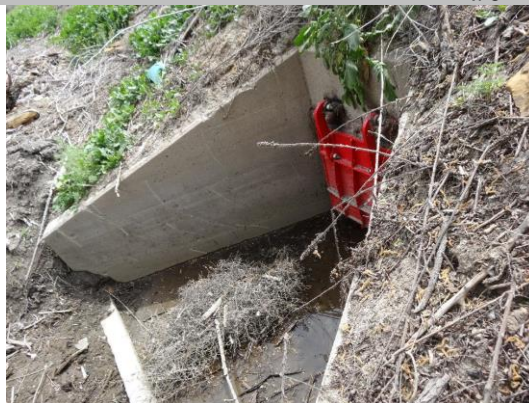
Photo 3 of 3 : UCIP\_SP\_2017\_36689\_66590.jpg

Item	DWR UCIP LMA Responsibility			37.113304 °	37.113304 °	
				-120.579102 °	-120.579102 °	
DWR ID						
Comment Code						
Inspector Comment						
FS_ID:36689						
DS_ID:19891						
EP_NO: N/A						
Repair Type: Non-Urgent						
Crossing Status: Found						
UCIP Comments: Dense vegetation limits the inspector's visibility to identify signs of pipe failure (leaks) along the slopes. Recommend removing vegetation along pipe alignment to conduct proper inspection of structure.						
FIELD_STRUCT_DESC: 2.5x2.5-foot R.C.B.C. through the levee, 14.0 feet below the crown. Flap gate on the waterward end. (USACE-1967). This entry matches the Drainage or Irrigation Structure referenced in O&M manual (HLM 19.85).						
FS Date: 4/17/2014

View of "U" concrete headwall located on waterward side.

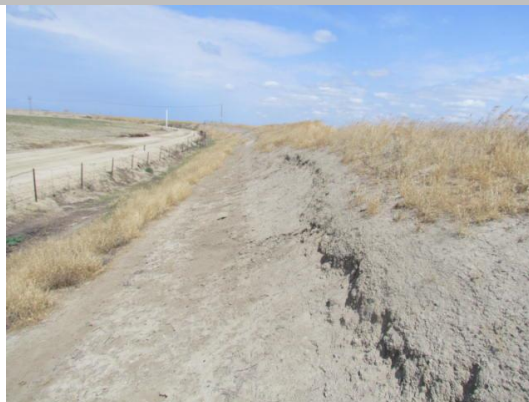
Photo 1 of 2 : SP\_2017\_NA0010\_124\_1209\_20170417\_00027.jpg

LM Start	20.79	Rating **	U	Issue No.	1209
LM End	20.88	Issue Type +	Ma	Location *	LS
Category	Earthen Levee			GPS Latitude/Longitude	
				Start	End
Item	Erosion / Bank Caving			37.113107 °	37.112176 °
				-120.563782 °	-120.562516 °
DWR ID	DWR_NA0010_06_s_2015_1209				
Comment Code					
E1 : Note and monitor erosion site.					
Inspector Comment					
Erosion on landward slope greater than 3 inches. Erosion caused by livestock.

Looking north at livestock erosion on landward slope.

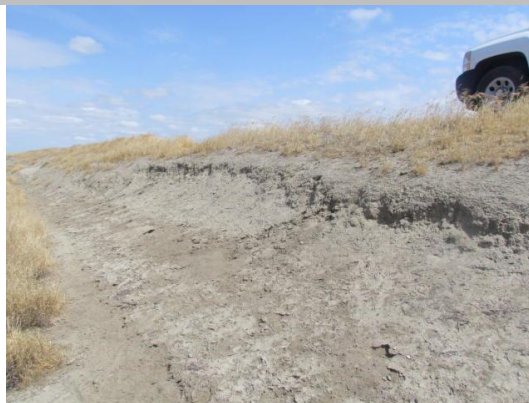
Photo 2 of 2 : SP\_2017\_NA0010\_124\_1209\_20170417\_00028.jpg

LM Start	20.79	Rating **	U	Issue No.	1209 (cont)	
LM End	20.88	Issue Type +	Ma	Location *	LS	
Category	Earthen Levee			GPS Latitude/Longitude		
				Start		End
Item	Erosion / Bank Caving			37.113107 °		37.112176 °
				-120.563782 °		-120.562516 °
DWR ID	DWR_NA0010_06_s_2015_1209					
Comment Code						
E1 : Note and monitor erosion site.						
Inspector Comment						
Erosion on landward slope greater than 3 inches. Erosion caused by livestock.

Looking northeast at livestock erosion on landward slope.

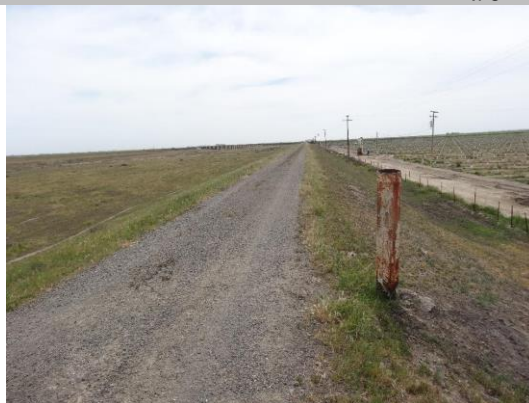
Photo 1 of 3 : UCIP\_SP\_2017\_34010\_61871.jpg

LM Start	24.02	Rating **	M	Issue No.	1260
LM End	24.02	Issue Type +	En	Location *	LS
Category	Supplemental			GPS Latitude/Longitude	
				Start	End
Item	DWR UCIP Field Study			37.077406 °	37.077406 °
				-120.525938 °	-120.525938 °
DWR ID					
Comment Code					
Inspector Comment					
FS_ID:34010					
DS_ID:19879					
EP_NO: 13638					
Repair Type: Non-Urgent					
Crossing Status: Found					
UCIP Comments: Need to contact owner to determine status. Crossing has been modified.					
FIELD_STRUCT_DESC: 16-inch steel pipe through levee, 3.5 feet below crown. Pump on the waterside. Siphon breaker on the landward shoulder. Cutoff wall around pipe at center of levee. Intake trench on waterward side. (Permit No. 13638-1984)					
FS Date: 4/17/2014

Overview of levee crown at crossing.

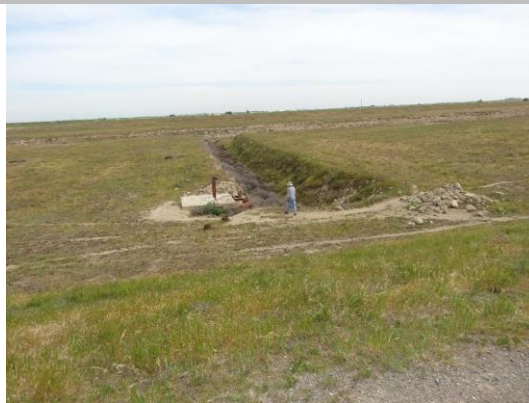
Photo 2 of 3 : UCIP\_SP\_2017\_34010\_61870.jpg

View of waterward side.

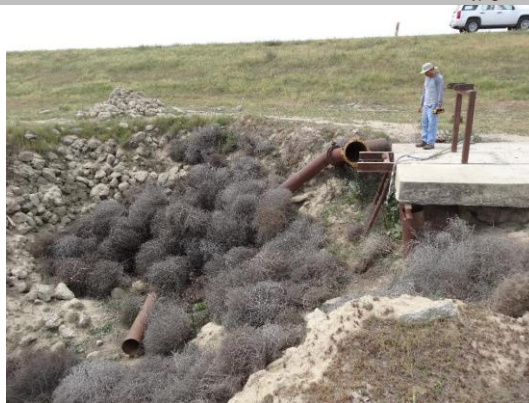
Photo 3 of 3 : UCIP\_SP\_2017\_34010\_61875.jpg

LM Start	24.02	Rating **	M	Issue No.	1260 (cont)
LM End	24.02	Issue Type +	En	Location *	LS
Category	Supplemental			GPS Latitude/Longitude	
				Start	End
Item	DWR UCIP Field Study			37.077406 °	37.077406 °
				-120.525938 °	-120.525938 °
DWR ID					
Comment Code					
Inspector Comment					
FS_ID:34010 DS_ID:19879 EP_NO: 13638 Repair Type: Non-Urgent Crossing Status: Found UCIP Comments: Need to contact owner to determine status. Crossing has been modified. FIELD_STRUCT_DESC: 16-inch steel pipe through levee, 3.5 feet below crown. Pump on the waterside. Siphon breaker on the landward shoulder. Cutoff wall around pipe at center of levee. Intake trench on waterward side. (Permit No. 13638-1984) FS Date: 4/17/2014

Concrete pad with abandoned support frame located on waterward side.

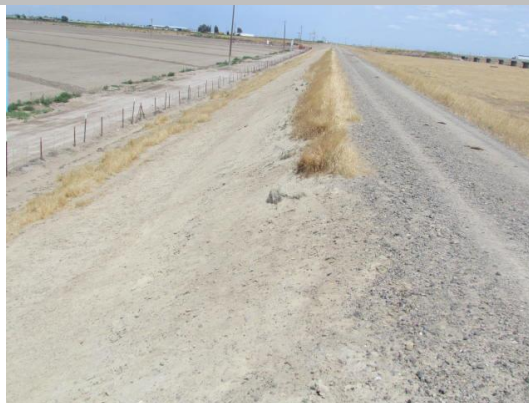
Photo 1 of 3 : SP\_2017\_NA0010\_124\_5\_20170417\_00007.jpg

LM Start	24.58	Rating **	M	Issue No.	5
LM End	24.93	Issue Type +	Ma	Location *	LS
Category	Earthen Levee			GPS Latitude/Longitude	
				Start	End
Item	Slope Stability			37.071198 °	°
				-120.519220 °	°
DWR ID	DWR_NA0010_06_s_2012_5				
Comment Code					
S2 : Repair the levee slope damaged by foot traffic and prevent access where possible.					
Inspector Comment					
Landside erosion caused by livestock.

Looking north at livestock erosion on landward slope. (Spring 2015)

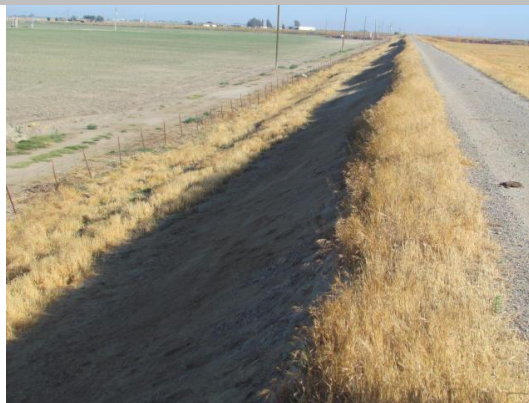
Photo 2 of 3 : SP\_2017\_NA0010\_124\_5\_20170417\_00008.jpg

LM Start	24.58	Rating **	M	Issue No.	5 (cont)	
LM End	24.93	Issue Type +	Ma	Location *	LS	
Category	Earthen Levee			GPS Latitude/Longitude		
				Start		End
Item	Slope Stability			37.071198°		°
				-120.519220°		°
DWR ID	DWR_NA0010_06_s_2012_5					
Comment Code						
S2 : Repair the levee slope damaged by foot traffic and prevent access where possible.						
Inspector Comment						
Landside erosion caused by livestock.

Looking north at livestock erosion on landward slope. (Spring 2014)

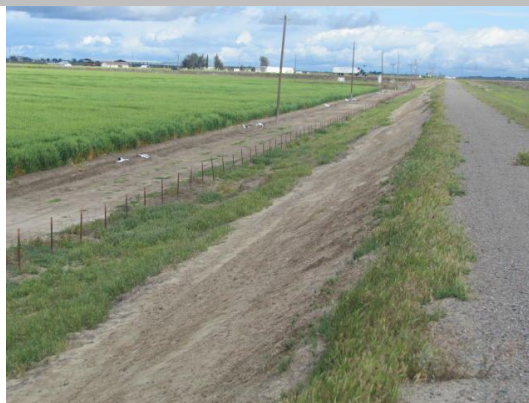
Photo 3 of 3 : SP\_2017\_NA0010\_124\_5\_20170417\_00009.jpg

Looking north at livestock erosion on landside slope. (Fall 2014)

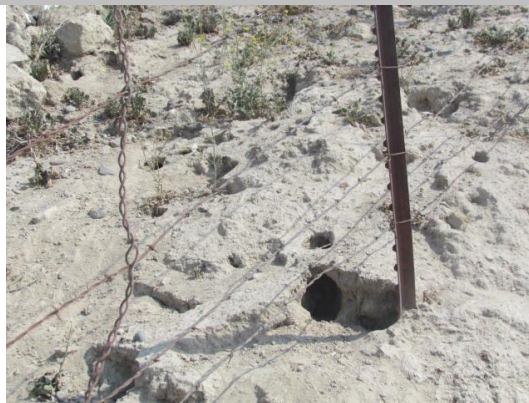
Photo 1 of 1 : SP\_2017\_NA0010\_124\_1208\_20170417\_00026.jpg

LM Start	26.13	Rating **	M	Issue No.	1208
LM End	26.13	Issue Type +	Ma	Location *	LS
Category	Earthen Levee			GPS Latitude/Longitude	
				Start	End
Item	Animal Control			37.054222 °	37.054222 °
				-120.500862 °	-120.500862 °
DWR ID	DWR_NA0010_06_s_2015_1208				
Comment Code					
A1 : Exterminate rodents and backfill and compact or grout burrows.					
Inspector Comment					
Noted several rodent holes next to and within rock revetment on landward slope.

Rodent holes on landward slope.

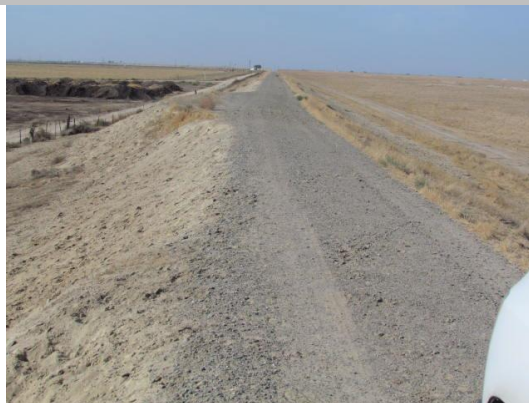
Photo 1 of 4 : SP\_2017\_NA0010\_124\_3\_20170417\_00003.jpg

LM Start	27.64	Rating **	M	Issue No.	3
LM End	27.97	Issue Type +	Ma	Location *	LS
Category	Earthen Levee			GPS Latitude/Longitude	
				Start	End
Item	Slope Stability			37.036955 °	37.032887 °
				-120.484395 °	-120.481225 °
DWR ID	DWR_NA0010_06_s_2012_3				
Comment Code					
S2 : Repair the levee slope damaged by foot traffic and prevent access where possible.					
Inspector Comment					
Landside erosion caused by livestock. Erosion greater than 3" in depth on landward slope. Levee crown has narrowed within this reach.

Looking north at livestock erosion on landward slope. Fall 2015

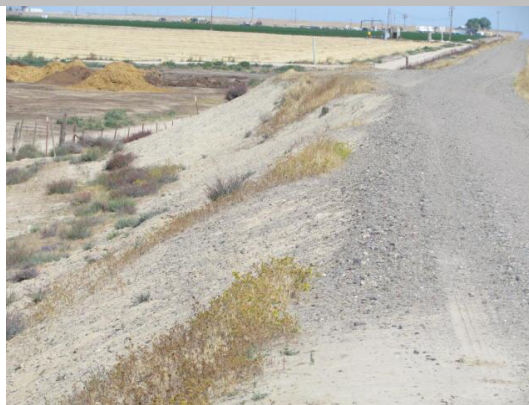
Photo 2 of 4 : SP\_2017\_NA0010\_124\_3\_20170417\_00004.jpg

Looking north at livestock erosion on landward shoulder and slope.(Spring 2015)

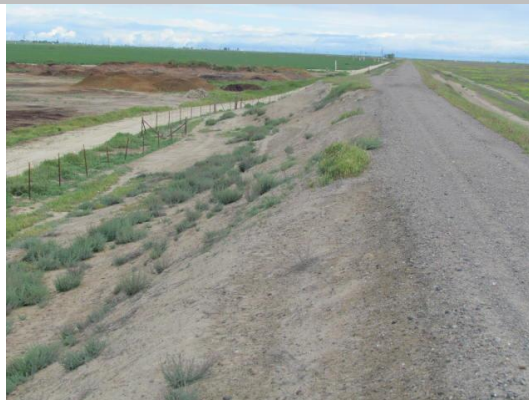
Photo 3 of 4 : SP\_2017\_NA0010\_124\_3\_20170417\_00005.jpg

Looking north at livestock erosion on landside shoulder and slope. (Fall 2014)

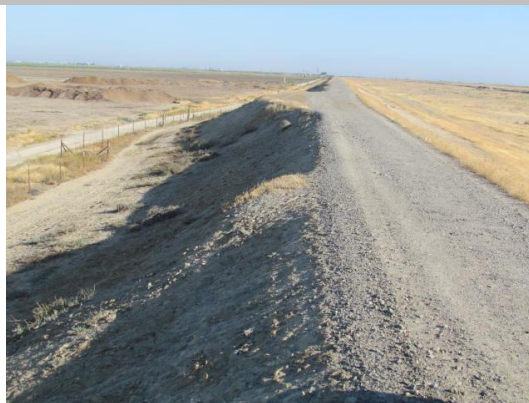
Photo 4 of 4 : SP\_2017\_NA0010\_124\_3\_20170417\_00006.jpg

LM Start	27.64	Rating **	M	Issue No.	3 (cont)	
LM End	27.97	Issue Type +	Ma	Location *	LS	
Category	Earthen Levee			GPS Latitude/Longitude		
				Start		End
Item	Slope Stability			37.036955 °		37.032887 °
				-120.484395 °		-120.481225 °
DWR ID	DWR_NA0010_06_s _ 2012_3					
Comment Code						
S2 : Repair the levee slope damaged by foot traffic and prevent access where possible.						
Inspector Comment						
Landside erosion caused by livestock. Erosion greater than 3" in depth on landward slope. Levee crown has narrowed within this reach.

Looking north at livestock erosion on landward slope. (Spring 2013)

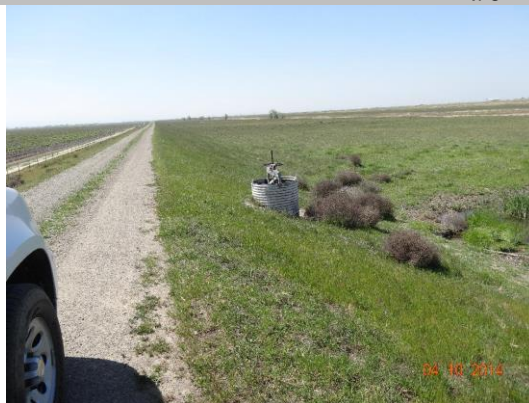
Photo 1 of 3 : UCIP\_SP\_2017\_39886\_66600.jpg

Comment Code					
Inspector Comment					
FS_ID:39886 DS_ID:19881 EP_NO: N/A Repair Type: Non-Urgent Crossing Status: Found UCIP Comments: Dense vegetation limits the inspector's visibility to identify signs of pipe failure (leaks) along the slopes. Recommend removing vegetation along pipe alignment to conduct proper inspection of structure. FIELD_STRUCT_DESC: 36-inch CM pipe through levee, 12.4 feet below crown. Slide gate in 48-inch CM pipe riser in the waterward slope. Concrete "U" headwall on both ends. Cobble pad on the landward side. (USACE-1967). This entry matches the Drainage or Irrigation Structure referenced in O&M manual (HLM 29.34). FS Date: 4/10/2014

View of waterward side--slide gate inside CMP riser located on waterward slope.

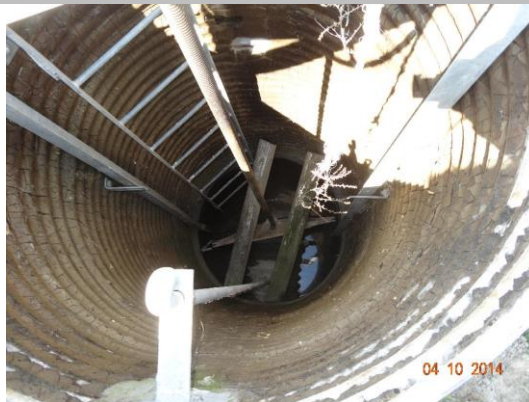
Photo 2 of 3 : UCIP\_SP\_2017\_39886\_66603.jpg

Inside view of CMP riser located on waterward slope.

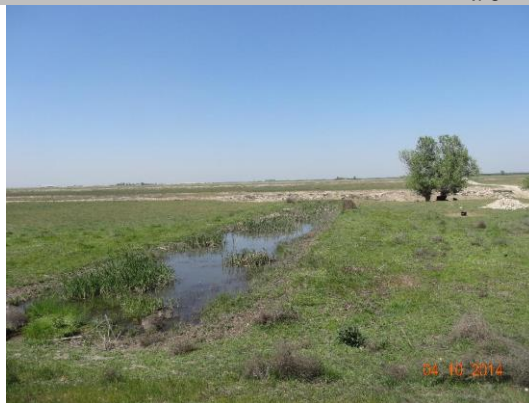
Photo 3 of 3 : UCIP\_SP\_2017\_39886\_66599.jpg

View of waterward side.

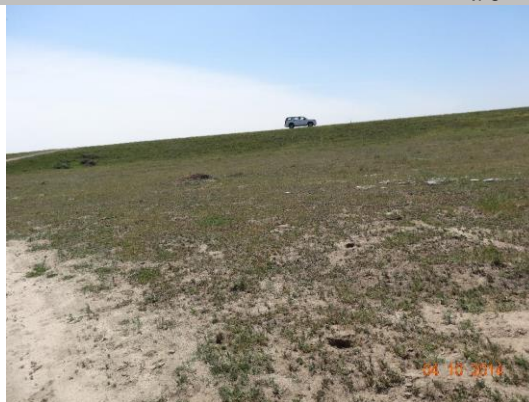
Photo 1 of 3 : UCIP\_SP\_2017\_36693\_66607.jpg

Comment Code					
Inspector Comment					
FS_ID:36693 DS_ID:19882 EP_NO: N/A Repair Type: Non-Urgent Crossing Status: Found UCIP Comments: Altered crossing--steel pipe section on landward side and concrete pipe section on waterward side. Joints on waterward side seperated. Need to contact owner to determine status. FIELD_STRUCT_DESC: [Rodunder Siphon Structure] 48-inch R.C. siphon pipe through the levee, 14.5 feet below the crown. Concrete "U" headwall on outlet structure on the landward end. Slide gate mounted on the headwall. (USACE-1967). This entry matches the Drainage or Irrigation Structure referenced in O&M manual (HLM 30.27). FS Date: 4/10/2014

Overview of waterward side.

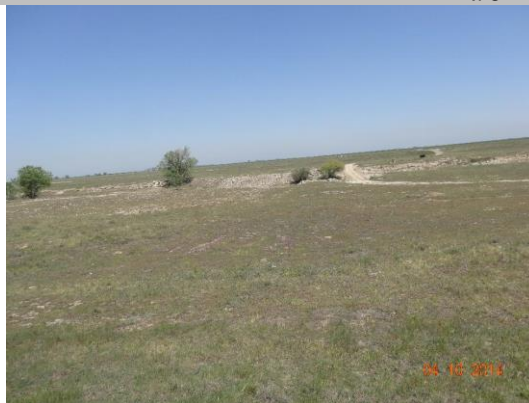
Photo 2 of 3 : UCIP\_SP\_2017\_36693\_66604.jpg

Overview of Eastside Bypass at crossing.

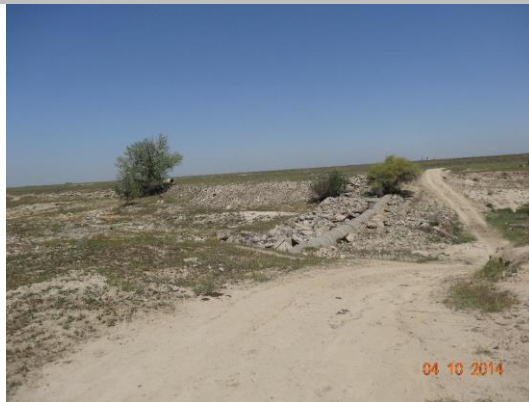
Photo 3 of 3 : UCIP\_SP\_2017\_36693\_66609.jpg

Concrete pipe through Eastside Bypass exposed.

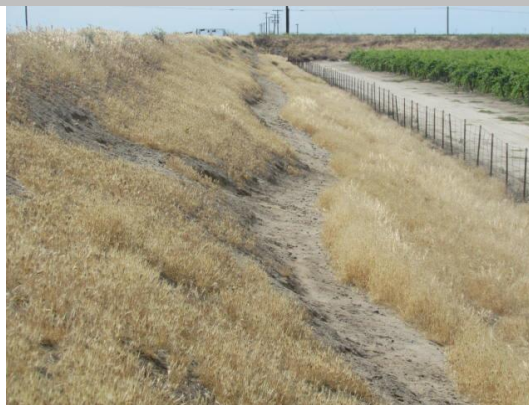
Photo 2 of 2 : SP\_2017\_NA0010\_124\_1207\_20170417\_00025.jpg

LM Start	30.81	Rating **	U	Issue No.	1207
LM End	31.06	Issue Type +	Ma	Location *	LS
Category	Earthen Levee			GPS Latitude/Longitude	
				Start	End
Item	Erosion / Bank Caving			37.021615 °	37.018428 °
				-120.437587 °	-120.435378 °
DWR ID	DWR_NA0010_06_s_2015_1207				
Comment Code					
E1 : Note and monitor erosion site.					
Inspector Comment					
Landward erosion greater than 1" in depth and greater than 3" in length. Erosion caused by livestock traffic.

Looking south at livestock erosion on landward slope.

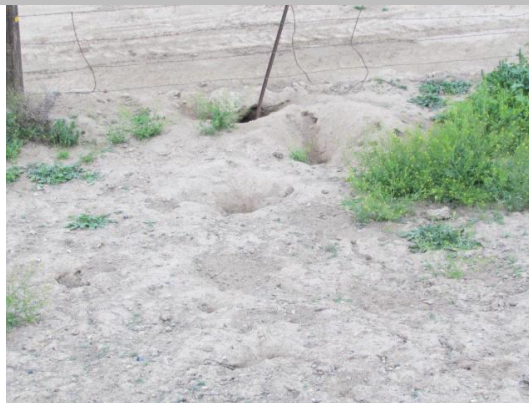
Photo 1 of 2 : SP\_2017\_NA0010\_124\_2\_20170417\_00001.jpg

LM Start	31.10	Rating **	U	Issue No.	2
LM End	31.10	Issue Type +	Ma	Location *	LS
Category	Earthen Levee			GPS Latitude/Longitude	
				Start	End
Item	Animal Control			37.017955 °	37.017955 °
				-120.435017 °	-120.435017 °
DWR ID	DWR_NA0010_06_s_2012_2				
Comment Code					
A1 : Exterminate rodents and backfill and compact or grout burrows.					
Inspector Comment

Looking west at rodent holes on landside slope and toe near fence line.

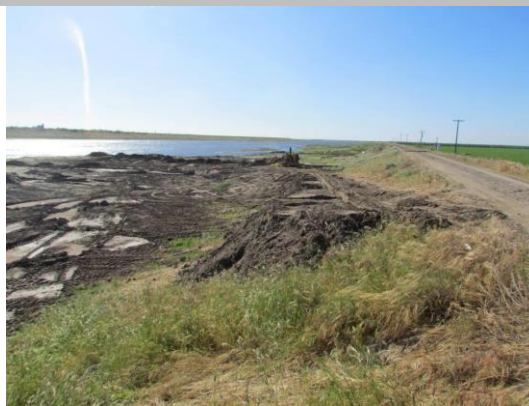
Photo 1 of 1 : SP\_2017\_NA0010\_124\_80\_20170425\_00170.jpg

LM Start	31.10	Rating **	U	Issue No.	80
LM End	31.10	Issue Type +	En	Location *	WS
Category	Earthen Levee			GPS Latitude/Longitude	
				Start	End
Item	Encroachments			37.017907 °	37.017907 °
				-120.434970 °	-120.434970 °
DWR ID	DWR_NA0010_06_s _ 2017_80				
Comment Code					
RA : Ramp					
Inspector Comment					
Farmer installed ramp on waterward slope.

Looking upstream at new ramp on waterward slope.

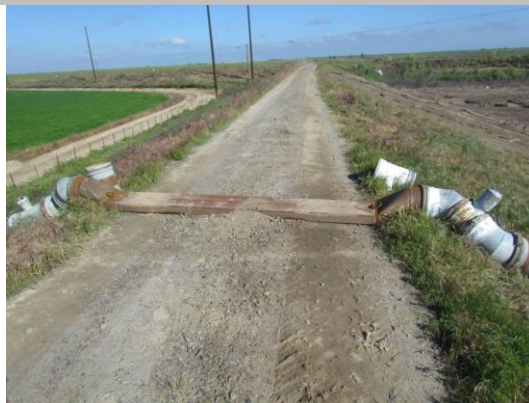
Photo 1 of 4 : SP\_2017\_NA0010\_124\_79\_20170425\_00172.jpg

LM Start	31.14	Rating **	U	Issue No.	79
LM End	31.14	Issue Type +	En	Location *	CR
Category	Earthen Levee			GPS Latitude/Longitude	
				Start	End
Item	Encroachments			37.017423 °	37.017423 °
				-120.434692 °	-120.434692 °
DWR ID	DWR_NA0010_06_s _ 2017_79				
Comment Code					
PI : Pipe					
Inspector Comment					
Farmer dug trench on waterward berm to siphon water from channel. Temporary eight inch pipes across levee.

Looking downstream at pipe cross on levee crown.

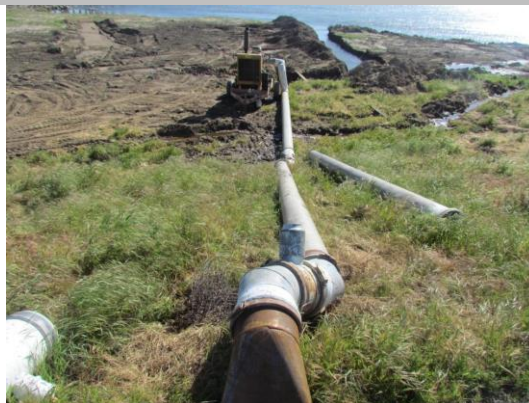
Photo 2 of 4 : SP\_2017\_NA0010\_124\_79\_20170425\_00173.jpg

Looking east at eight inch pipe on waterward slope and berm.

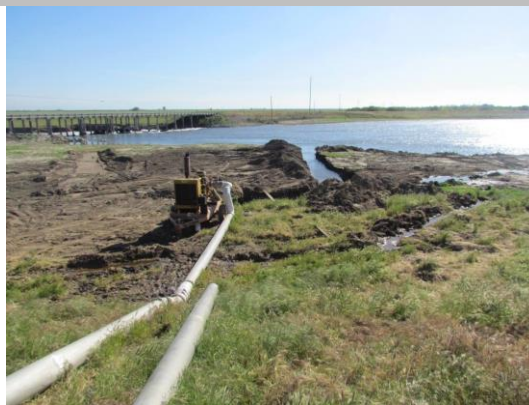
Photo 3 of 4 : SP\_2017\_NA0010\_124\_79\_20170425\_00171.jpg

Looking east at pump and trench on waterward berm.

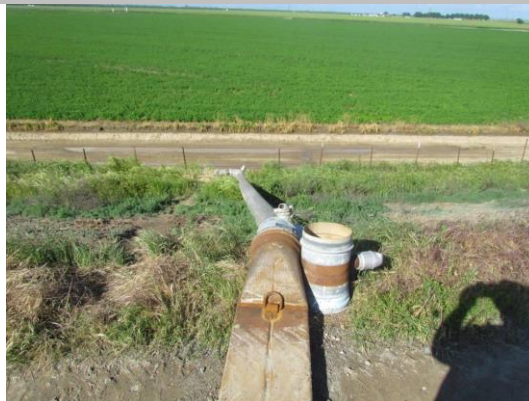
Photo 4 of 4 : SP\_2017\_NA0010\_124\_79\_20170425\_00174.jpg

Looking west at eight inch pipe on landward slope.

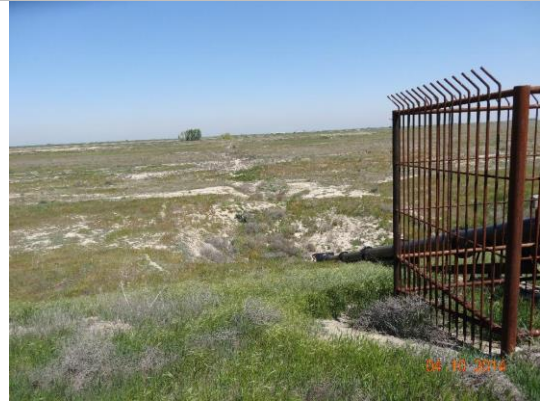
Photo 3 of 3 : UCIP\_SP\_2017\_46183\_61903.jpg

LM Start	33.08	Rating **	M	Issue No.	1263 (cont)
LM End	33.08	Issue Type +	En	Location *	CR
Category	Supplemental			GPS Latitude/Longitude	
				Start	End
Item	DWR UCIP Field Study			36.995672 °	36.995672 °
				-120.412919 °	-120.412919 °
DWR ID					
Comment Code					
Inspector Comment					
FS_ID:46183 DS_ID:19883 EP_NO: 6416A Repair Type: Non-Urgent Crossing Status: Found UCIP Comments: Crossing updated--need to contact owner to determine permit issued by CVFPB for authorized changes. FIELD_STRUCT_DESC: 20-inch (not 18 inch as mentioned in DS study) steel pipe through the levee, 3.9 feet below crown. Electrical conduit through levee. Capped with welded plate on landward end. Siphon breaker on apex of pipe on the landward shoulder. Cutoff wall around pipe at centerline of levee. Slant pump on waterward slope. (Permit No. 6416A-1980) FS Date: 4/10/2014

View of Eastside Bypass.

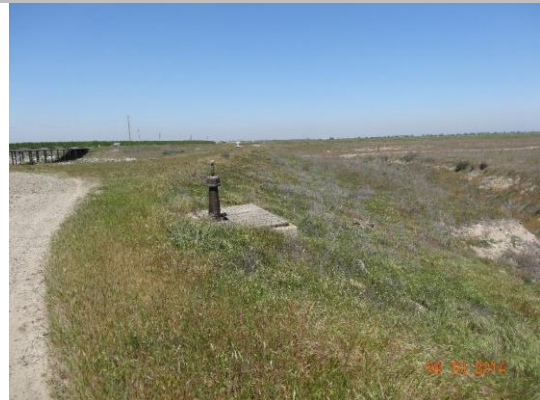
Photo 1 of 3 : UCIP\_SP\_2017\_39481\_66628.jpg

Comment Code					
Inspector Comment					
FS_ID:39481 DS_ID:19813 EP_NO: N/A Repair Type: Non-Urgent Crossing Status: Found UCIP Comments: Dense vegetation limits the inspector's visibility to identify signs of pipe failure (leaks) along the slope. Recommend removing vegetation along pipe alignment to conduct proper inspection of structure and appurtenances. High vegetation along crossing alignment--recommend removing vegetation along pipe crossing. FIELD_STRUCT_DESC: 48x72-inch through the levee, 15.1 feet below the crown. Slide gate in concrete riser in the waterward slope. Concrete "U" headwall on both ends. Landside channel cobble revetted for 8.0 feet. (USACE-1967). This entry matches the Drainage or Irrigation Structure referenced in O&M manual (HLM 35.33). FS Date: 4/10/2014

View of waterward side--slide gate inside concrete box.

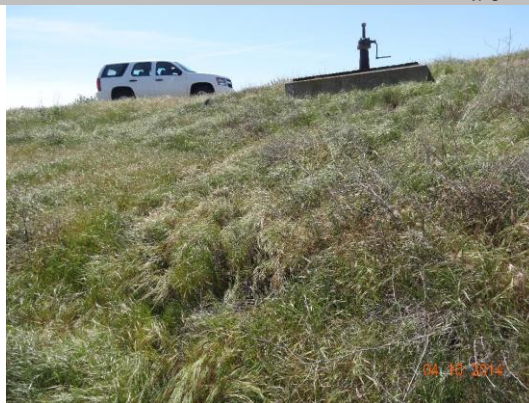
Photo 2 of 3 : UCIP\_SP\_2017\_39481\_66632.jpg

View of waterward slope covered by dense vegetation.

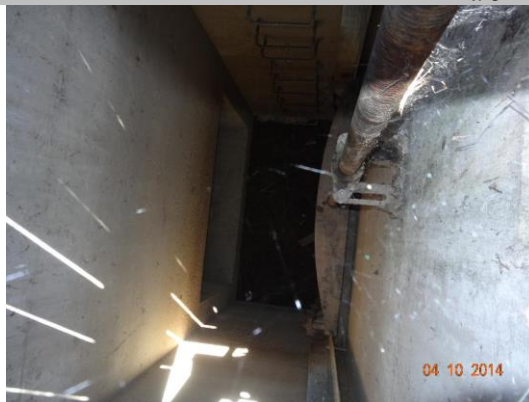
Photo 3 of 3 : UCIP\_SP\_2017\_39481\_66629.jpg

Inside view of concrete box located on waterward slope.

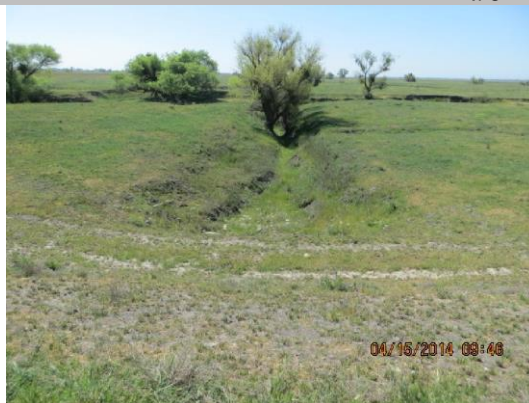
Photo 1 of 3 : UCIP\_SP\_2017\_49966\_60954.jpg

FS\_ID:49966  
DS\_ID:19892  
EP\_NO: N/A  
Repair Type: Non-Urgent  
Crossing Status: Found  
UCIP Comments: 07/20/2016 Inlet blocked off by wooden board. Dense vegetation limits the inspector's visibility to identify signs of pipe failure (leaks) along WS and LS. Crossing downgraded from Urgent to Non-Urgent. (DWR UCIP - omagana)04/15/2014 Flapgate partially blocked by soil buildup at WS toe. (DWR UCIP - omagana)  
FIELD\_STRUCT\_DESC: 24-inch corrugated metal drainage pipe through the levee, 10.8 feet below the crown. Flap gate located on the waterside (WS) end. Concrete headwall located on the landside (LS) end. Concrete "U" headwall located on the WS end. [Additional Reference(s): DWR Levee Log, 2002. USACE San Joaquin O&M Manuals: Unit No. 601, 1967, (HLM 0.07), Unit No. 601 Part I, 1967 (Amended in 1978), Unit No. 601 Part II, 1969, and Unit No. 601 Part III, 1969]  
FS Date: 7/20/2016

Pipe and headwall at WS toe.

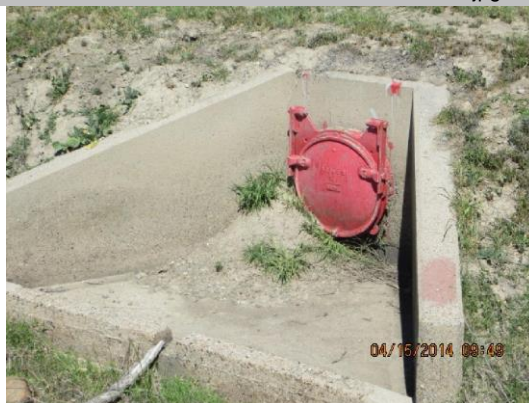
Photo 2 of 3 : UCIP\_SP\_2017\_49966\_60955.jpg

Pipe, headwall, and flapgate at WS toe. Soil buildup partially blocking flapgate.

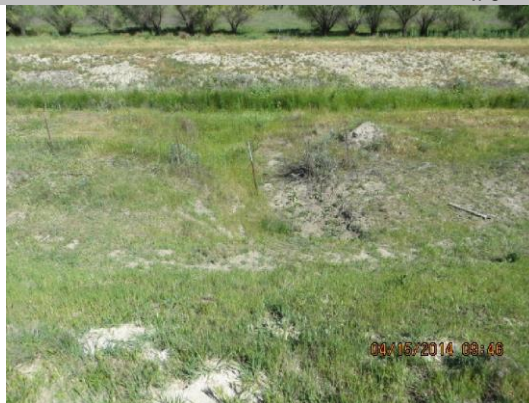
Photo 3 of 3 : UCIP\_SP\_2017\_49966\_60953.jpg

Pipe and headwall at LS toe.

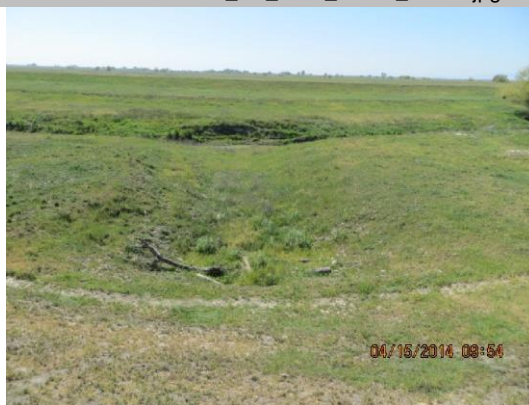
Photo 1 of 3 : UCIP\_SP\_2017\_33712\_60958.jpg

LM Start	0.33	Rating **	A/W	Issue No.	31
LM End	0.33	Issue Type +	Ma	Location *	LS
Category	Supplemental			GPS Latitude/Longitude	
				Start	End
Item	DWR UCIP LMA Responsibility			37.257691 °	37.257691 °
				-120.767203 °	-120.767203 °
DWR ID					
Comment Code					
Inspector Comment					
FS_ID:33712					
DS_ID:19893					
EP_NO: N/A					
Repair Type: No Action Needed					
Crossing Status: Found					
UCIP Comments:					
FIELD_STRUCT_DESC: 24-inch C.M stormdrain pipe through the					
levee, 11.1 feet below the crown. Flap gate on the waterward end.					
Concrete headwall on the landward end. Concrete "U" headwall on the					
waterward end. (USACE-1967). This entry matches the Drainage or					
Irrigation Structure referenced in O&M manual (HLM 0.33).					
FS Date: 4/15/2014

Pipe and headwall on WS toe.

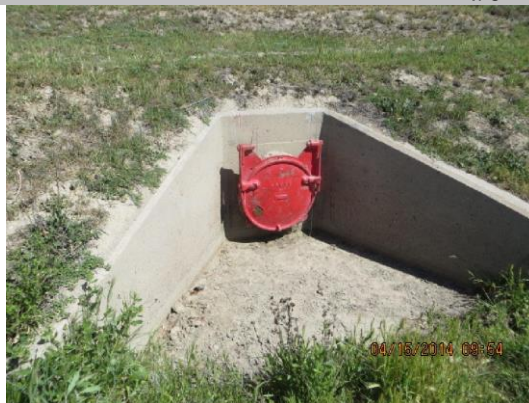
Photo 2 of 3 : UCIP\_SP\_2017\_33712\_60957.jpg

LM Start	0.33	Rating **	A/W	Issue No.	31 (cont)	
LM End	0.33	Issue Type +	Ma	Location *	LS	
Category	Supplemental			GPS Latitude/Longitude		
				Start		End
Item	DWR UCIP LMA Responsibility			37.257691 °	37.257691 °	
				-120.767203 °	-120.767203 °	
DWR ID						
Comment Code						
Inspector Comment						
FS_ID:33712						
DS_ID:19893						
EP_NO: N/A						
Repair Type: No Action Needed						
Crossing Status: Found						
UCIP Comments:						
FIELD_STRUCT_DESC: 24-inch C.M stormdrain pipe through the						
levee, 11.1 feet below the crown. Flap gate on the waterward end.						
Concrete headwall on the landward end. Concrete "U" headwall on the						
waterward end. (USACE-1967). This entry matches the Drainage or						
Irrigation Structure referenced in O&M manual (HLM 0.33).						
FS Date: 4/15/2014

Pipe, headwall, and flapgate on WS toe.

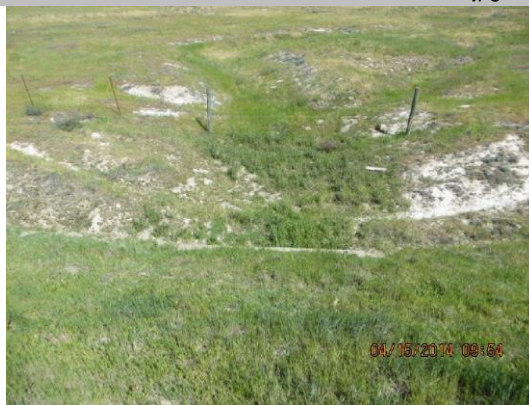
Photo 3 of 3 : UCIP\_SP\_2017\_33712\_60959.jpg

LM Start	<b>0.33</b>	Rating **	A/W	Issue No.	<b>31 (cont)</b>
LM End	<b>0.33</b>	Issue Type +	Ma	Location *	LS

Pipe and headwall on LS toe.
